**Flood Control Project Maintenance
Levee Inspections**

Maintenance Issue Types Only, Levee Inspection Report By Mile - Spring 2017

Lower San Joaquin Levee District

Waterway	Bank	Unit Miles	Inspection Start/End	Inspector
Unit No. 01 San Joaquin River	Right	22.52	04/17/2017 04/20/2017	Richard Willoughby

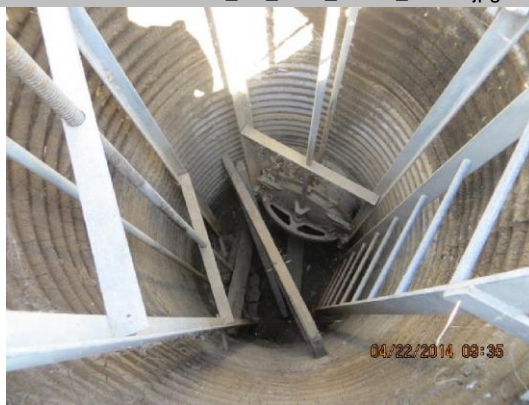
Photo 2 of 3 : UCIP_SP_2017_34186_62133.jpg

Inside CMP riser on WS slope.

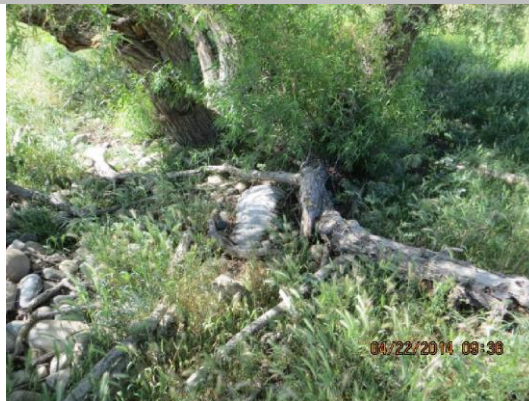
Photo 3 of 3 : UCIP_SP_2017_34186_62137.jpg

Outlet at WS toe.

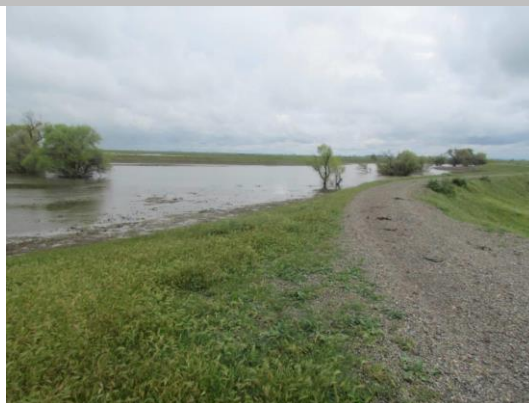
Photo 1 of 1 : SP_2017_NA0010_128_2_20170425_00005.jpg

LM Start	0.00	Rating **	M	Issue No.	2
LM End	0.79	Issue Type +	Ma	Location *	WS
Category	Earthen Levee			GPS Latitude/Longitude	
				Start	End
Item	Vegetation			37.217905 °	37.219367 °
				-120.711465 °	-120.698023 °
DWR ID	DWR_NA0010_10_s_2017_2				
Comment Code					
V1 : Control annual grass and weeds on the levee slopes and easements.					
Inspector Comment

Looking upstream at typical view of landward slope.

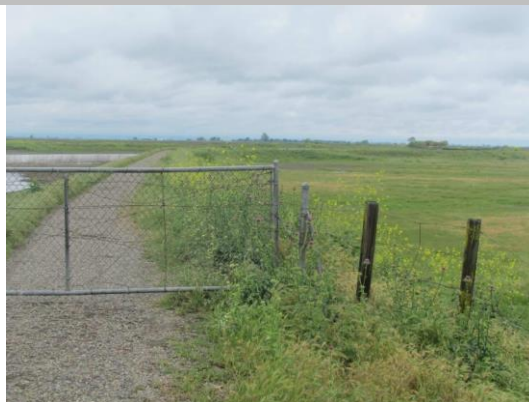
Photo 1 of 1 : SP_2017_NA0010_128_3_20170425_00004.jpg

LM Start	0.00	Rating **	M	Issue No.	3
LM End	0.79	Issue Type +	Ma	Location *	LS
Category	Earthen Levee			GPS Latitude/Longitude	
				Start	End
Item	Vegetation			37.217905 °	37.219367 °
				-120.711465 °	-120.698023 °
DWR ID	DWR_NA0010_10_s_2017_3				
Comment Code					
V1 : Control annual grass and weeds on the levee slopes and easements.					
Inspector Comment

Looking downstream at typical view of landward slope.

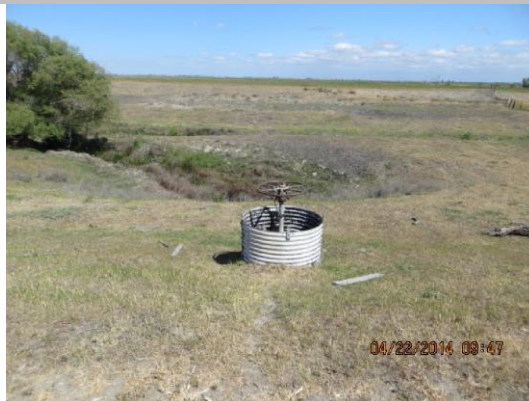
Photo 1 of 3 : UCIP_SP_2017_39516_62144.jpg

FS_ID:39516
DS_ID:19845
EP_NO: N/A
Repair Type: Non-Urgent
Crossing Status: Found
UCIP Comments: Inlet blocked at LS toe by wooden gate. Need to contact owner to determine status.
FIELD_STRUCT_DESC: 36-inch CM stormdrain pipe through levee, 19.6-feet below crown. Slide gate in 48-inch CM pipe riser on the waterward slope. Concrete "U" headwalls on both ends. (USACE-1967). This entry matches the Drainage or Irrigation Structure referenced in O&M manual (HLM 0.31).
FS Date: 4/22/2014

Headwall and pipe visible on LS toe. Slide gate inside 48-inch CMP riser on WS slope.

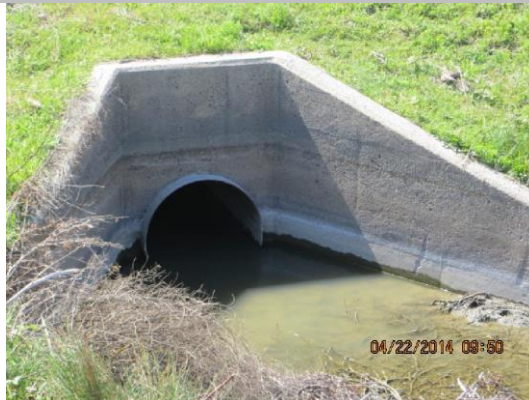
Photo 2 of 3 : UCIP_SP_2017_39516_62146.jpg

Headwall and pipe on WS toe.

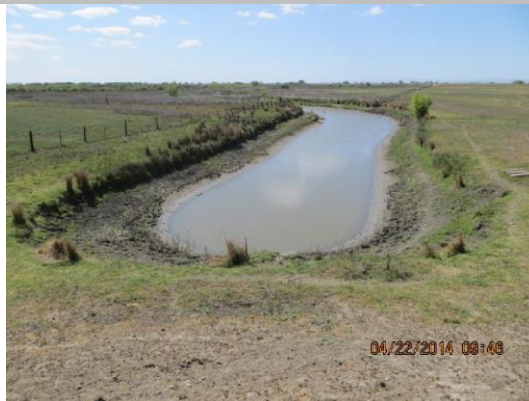
Photo 3 of 3 : UCIP_SP_2017_39516_62145.jpg

Headwall and pipe on LS toe. Pipe blocked by wooden cover.

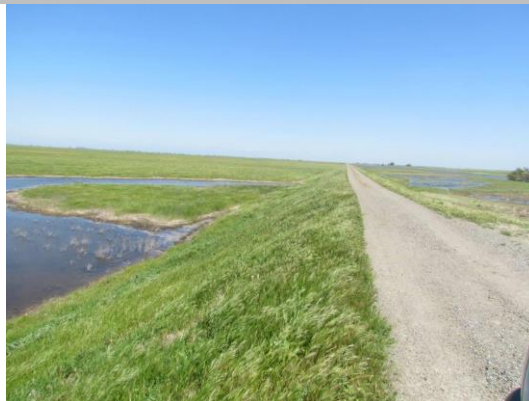
Photo 1 of 1 : SP_2017_NA0010_129_9_20170425_00022.jpg

LM Start	0.00	Rating **	M	Issue No.	9
LM End	3.31	Issue Type +	Ma	Location *	LS
Category	Earthen Levee			GPS Latitude/Longitude	
				Start	End
Item	Vegetation			37.202748 °	37.202308 °
				-120.755283 °	-120.695252 °
DWR ID	DWR_NA0010_11_s_2017_9				
Comment Code					
V1 : Control annual grass and weeds on the levee slopes and easements.					
Inspector Comment

Looking at typical view of landward slope.

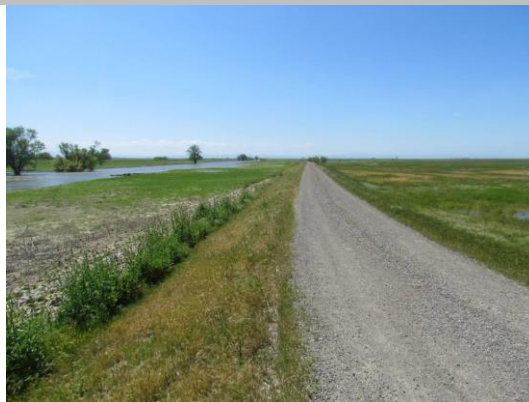
Photo 1 of 1 : SP_2017_NA0010_129_10_20170425_00023.jpg

LM Start	0.00	Rating **	M	Issue No.	10
LM End	3.31	Issue Type +	Ma	Location *	WS
Category	Earthen Levee			GPS Latitude/Longitude	
				Start	End
Item	Vegetation			37.202748 °	37.202308 °
				-120.755283 °	-120.695252 °
DWR ID	DWR_NA0010_11_s_2017_10				
Comment Code					
V1 : Control annual grass and weeds on the levee slopes and easements.					
Inspector Comment

Looking at typical view of waterward slope.

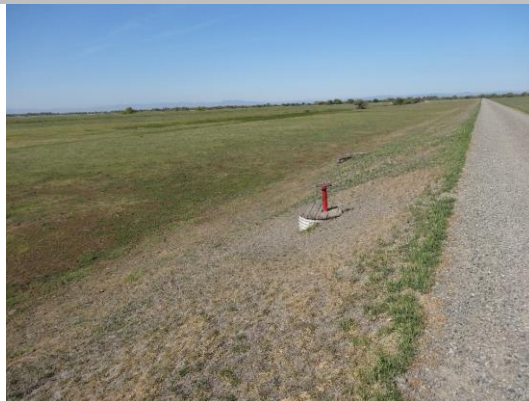
Photo 1 of 3 : UCIP_SP_2017_39517_66644.jpg

View of slide gate inside CMP riser located on waterward slope.

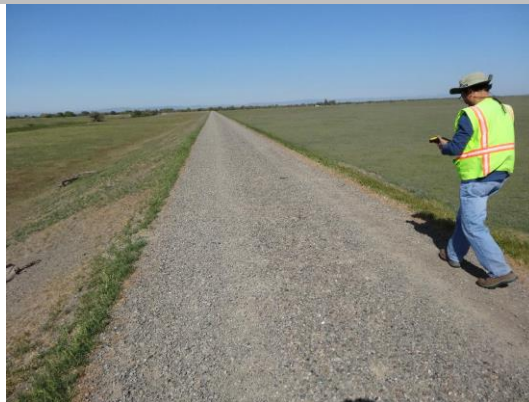
Photo 2 of 3 : UCIP_SP_2017_39517_66643.jpg

View of levee crown at crossing.

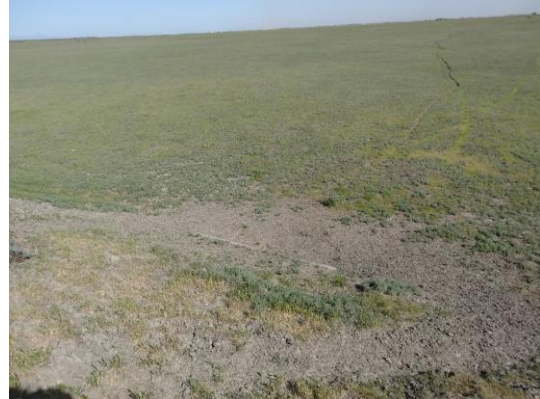
Photo 3 of 3 : UCIP_SP_2017_39517_66642.jpg

View of landward side.

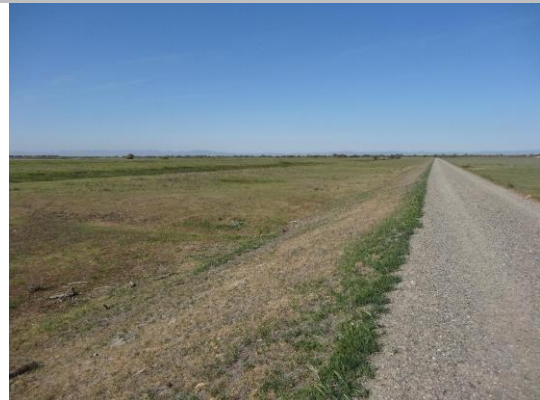
Photo 1 of 3 : UCIP_SP_2017_39518_61997.jpg

View of waterward side.

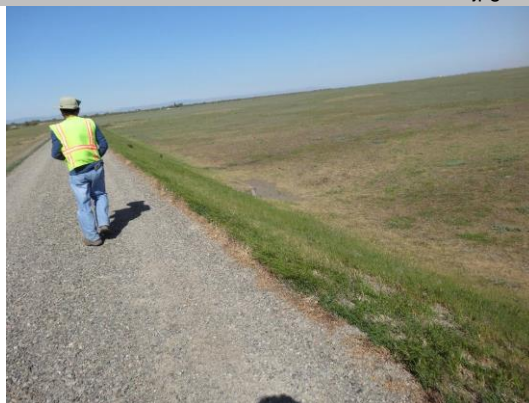
Photo 2 of 3 : UCIP_SP_2017_39518_61996.jpg

View of landward side.

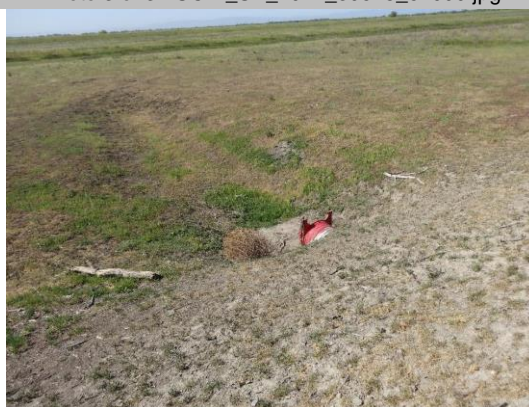
Photo 3 of 3 : UCIP_SP_2017_39518_61999.jpg

Flap gate and concrete apron located on waterward side.

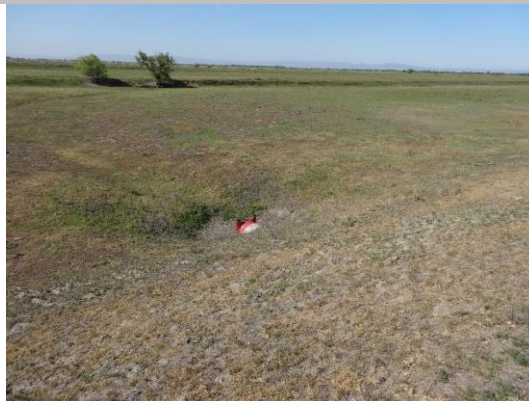
Photo 1 of 3 : UCIP_SP_2017_39519_62003.jpg

Overview of waterward side.

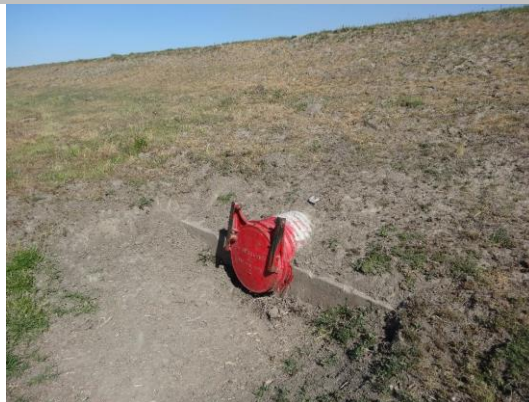
Photo 2 of 3 : UCIP_SP_2017_39519_62002.jpg

Concrete headwall and flap gate visible on waterward side.

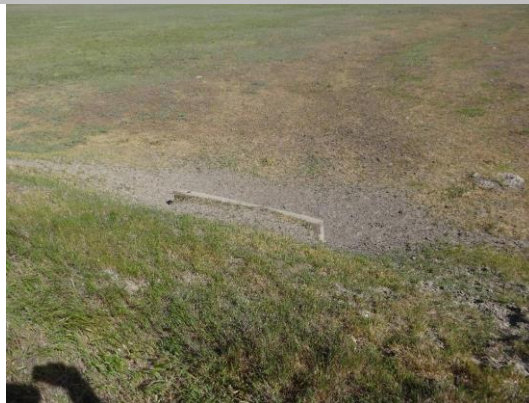
Photo 3 of 3 : UCIP_SP_2017_39519_62001.jpg

View of landward side.

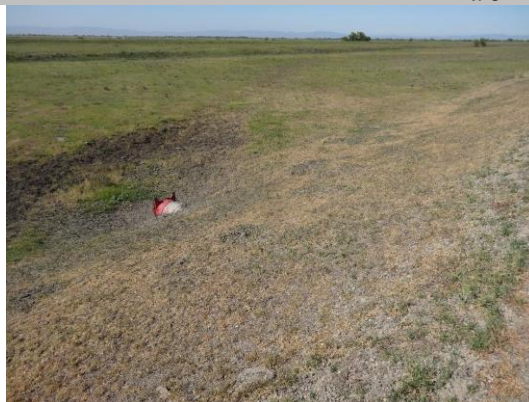
Photo 1 of 3 : UCIP_SP_2017_39520_62008.jpg

View of waterward side--flap gate visible at levee toe.

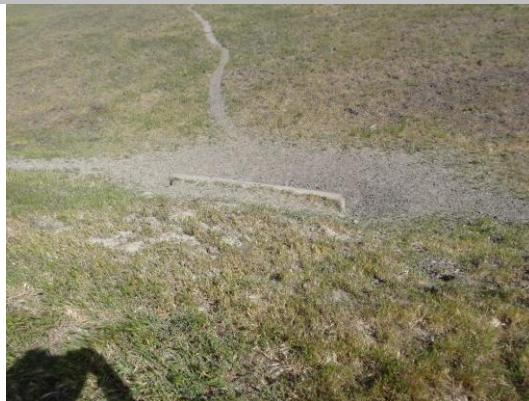
Photo 2 of 3 : UCIP_SP_2017_39520_62007.jpg

View of landward side.

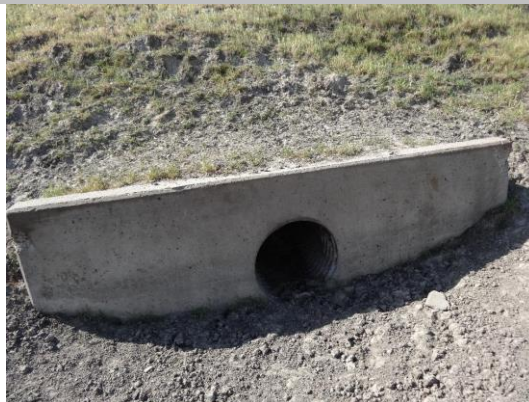
Photo 3 of 3 : UCIP_SP_2017_39520_62006.jpg

Concrete headwall located on landward side.

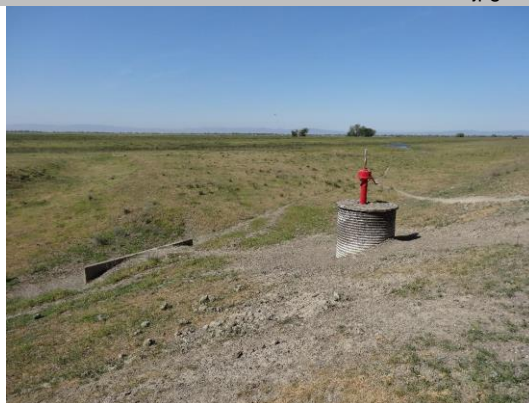
Photo 1 of 3 : UCIP_SP_2017_39521_62018.jpg

View of waterward side.

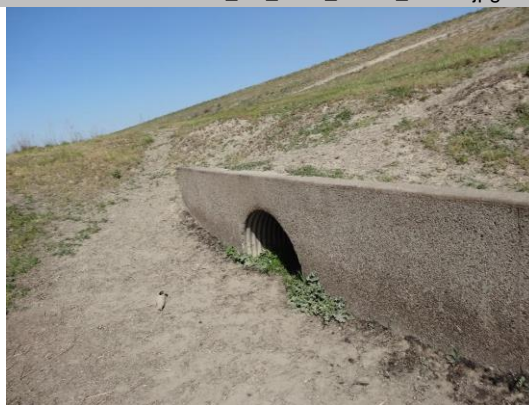
Photo 2 of 3 : UCIP_SP_2017_39521_62017.jpg

View of concrete headwall located on waterward side.

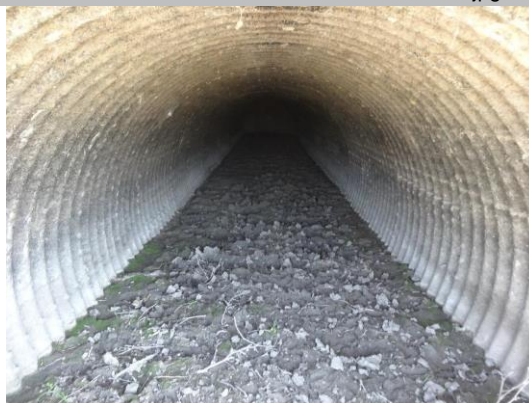
Photo 3 of 3 : UCIP_SP_2017_39521_62016.jpg

LM Start	1.49	Rating **	M	Issue No.	15 (cont)	
LM End	1.49	Issue Type +	Ma	Location *	WS	
Category	Supplemental			GPS Latitude/Longitude		
				Start		End
Item	DWR UCIP LMA Responsibility			37.202753 °		37.202753 °
				-120.728133 °		-120.728133 °
DWR ID						
Comment Code						
Inspector Comment						
FS_ID:39521						
DS_ID:19850						
EP_NO: N/A						
Repair Type: Non-Urgent						
Crossing Status: Found						
UCIP Comments: Need to contact owner. Recommend clearing sediment deposit inside pipe.						
FIELD_STRUCT_DESC: 48-inch C.M. pipe through the levee, 16.3 feet below the crown. Slide gate in riser pipe on the waterward slope. (USACE-1967). This entry matches the Drainage or Irrigation Structure referenced in O&M manual (HLM 1.50).						
FS Date: 4/18/2014

Inside view of pipe from waterward side--sediment build up.

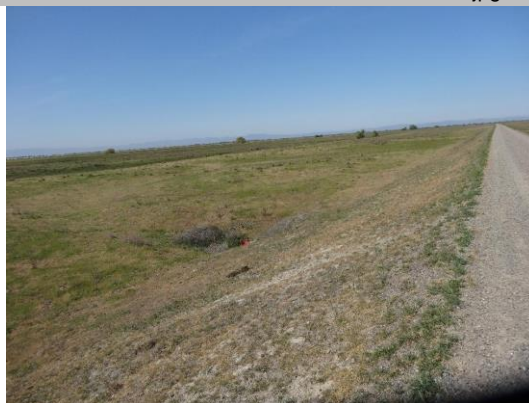
Photo 1 of 3 : UCIP_SP_2017_39522_62024.jpg

LM Start	1.98	Rating **	M	Issue No.	16
LM End	1.98	Issue Type +	Ma	Location *	LS
Category	Supplemental			GPS Latitude/Longitude	
				Start	End
Item	DWR UCIP LMA Responsibility			37.202740 °	37.202740 °
				-120.719247 °	-120.719247 °
DWR ID					
Comment Code					
Inspector Comment					
FS_ID:39522					
DS_ID:19851					
EP_NO: N/A					
Repair Type: Non-Urgent					
Crossing Status: Found					
UCIP Comments: Need to contact owner. Recommend clearing sediment deposit inside pipe.					
FIELD_STRUCT_DESC: 24-inch C.M. pipe through the levee, 12.8 feet below the crown. Flap gate on the waterward end. (USACE-1967). This entry matches the Drainage or Irrigation Structure referenced in O&M manual (HLM 1.99).					
FS Date: 4/18/2014

View of waterward side.

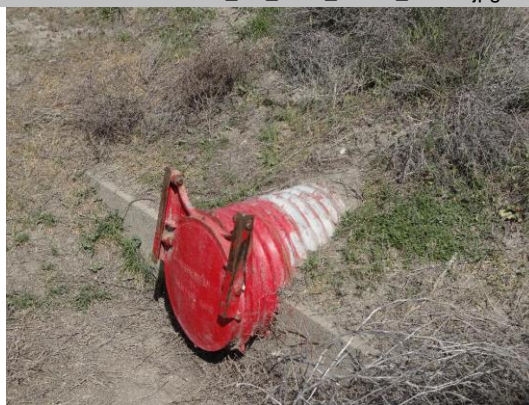
Photo 2 of 3 : UCIP_SP_2017_39522_62025.jpg

Flap gate located on waterward side.

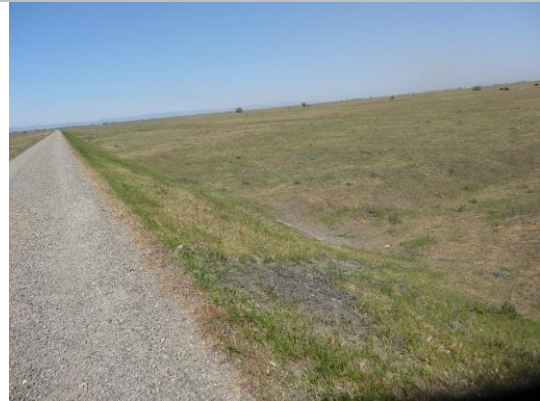
Photo 3 of 3 : UCIP_SP_2017_39522_62023.jpg

View of landward side.

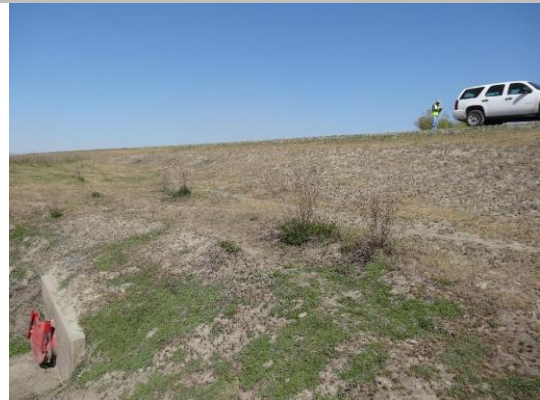
Photo 1 of 3 : UCIP_SP_2017_39523_62028.jpg

LM Start	3.04	Rating **	M	Issue No.	17
LM End	3.04	Issue Type +	Ma	Location *	LS
Category	Supplemental			GPS Latitude/Longitude	
				Start	End
Item	DWR UCIP LMA Responsibility			37.202494 °	37.202494 °
				-120.700153 °	-120.700153 °
DWR ID					
Comment Code					
Inspector Comment					
FS_ID:39523					
DS_ID:19852					
EP_NO: N/A					
Repair Type: Non-Urgent					
Crossing Status: Found					
UCIP Comments: Need to contact owner. Recommend clearing sediment deposit inside pipe.					
FIELD_STRUCT_DESC: 24-inch C.M. pipe through the levee, 15.0 feet below the crown. Flap gate on the waterward end. (USACE-1967). This entry matches the Drainage or Irrigation Structure referenced in O&M manual (HLM 3.04).					
FS Date: 4/18/2014

Overview of waterward side--flap gate, concrete headwall and apron visible on levee toe.

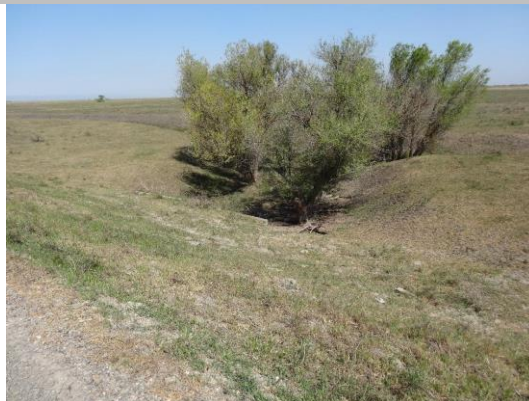
Photo 2 of 3 : UCIP_SP_2017_39523_62027.jpg

View of landward side.

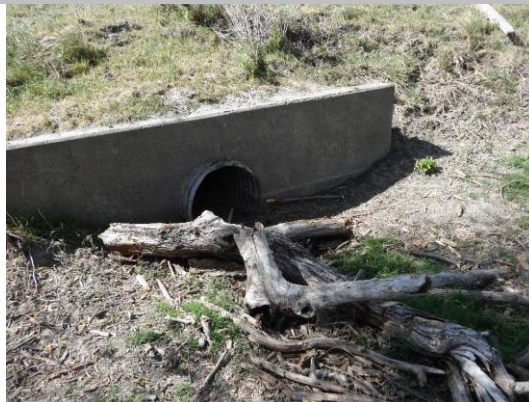
Photo 3 of 3 : UCIP_SP_2017_39523_62030.jpg

Concrete headwall located on landward side--debris in front of headwall.

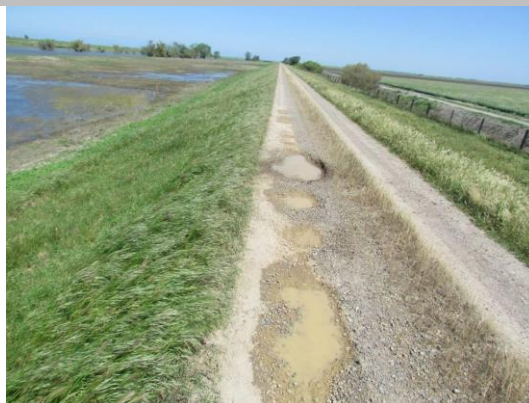
Photo 1 of 1 : SP_2017_NA0010_130_12_20170425_00022.jpg

LM Start	0.00	Rating **	M	Issue No.	12
LM End	2.75	Issue Type +	Ma	Location *	CR
Category	Earthen Levee			GPS Latitude/Longitude	
				Start	End
Item	Crown Surface / Depressions / Rutting			37.200958 °	37.200918 °
				-120.755207 °	-120.705467 °
DWR ID	DWR_NA0010_12_s_2017_12				
Comment Code					
C2 : Repair depressions or ruts in the crown or slope.					
Inspector Comment					
Several pot holes along levee crown.

Looking downstream at typical view of pot holes and rutting on levee crown.

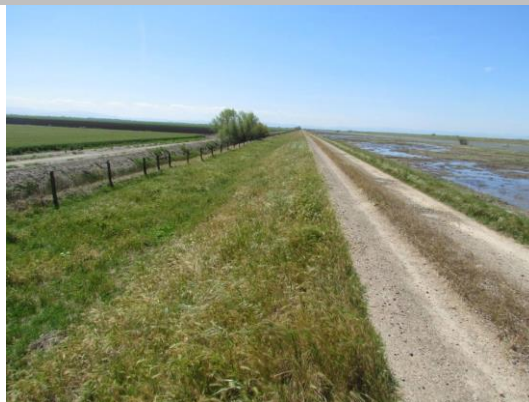
Photo 1 of 1 : SP_2017_NA0010_130_10_20170425_00024.jpg

LM Start	0.00	Rating **	M	Issue No.	10
LM End	3.33	Issue Type +	Ma	Location *	LS
Category	Earthen Levee			GPS Latitude/Longitude	
				Start	End
Item	Vegetation			37.200958 °	37.201045 °
				-120.755207 °	-120.694823 °
DWR ID	DWR_NA0010_12_s_2017_10				
Comment Code					
V1 : Control annual grass and weeds on the levee slopes and easements.					
Inspector Comment

Looking at typical view of landward slope.

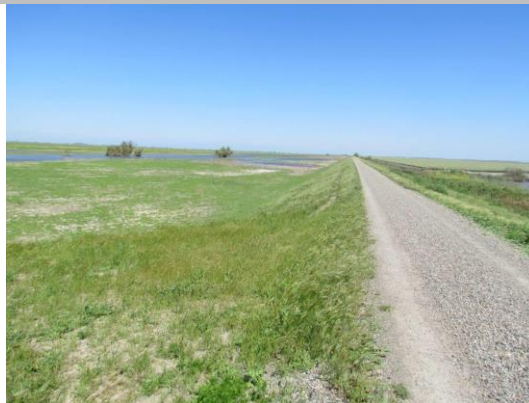
Photo 1 of 1 : SP_2017_NA0010_130_11_20170425_00023.jpg

LM Start	0.00	Rating **	M	Issue No.	11
LM End	3.33	Issue Type +	Ma	Location *	WS
Category	Earthen Levee			GPS Latitude/Longitude	
				Start	End
Item	Vegetation			37.200958 °	37.201045 °
				-120.755207 °	-120.694823 °
DWR ID	DWR_NA0010_12_s_2017_11				
Comment Code					
V1 : Control annual grass and weeds on the levee slopes and easements.					
Inspector Comment

Looking at typical view of waterward slope.

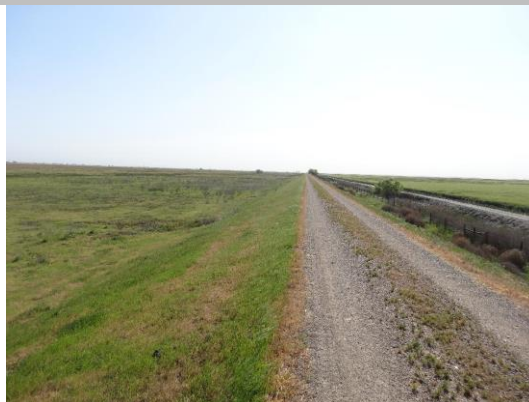
Photo 1 of 3 : UCIP_SP_2017_36704_66647.jpg

LM Start	0.40	Rating **	M	Issue No.	13
LM End	0.40	Issue Type +	Ma	Location *	WS
Category	Supplemental			GPS Latitude/Longitude	
				Start	End
Item	DWR UCIP LMA Responsibility			37.200934 °	37.200934 °
				-120.747996 °	-120.747996 °
DWR ID					
Comment Code					
Inspector Comment					
FS_ID:36704 DS_ID:19855 EP_NO: N/A Repair Type: Non-Urgent Crossing Status: Found UCIP Comments: Need to contact owner. Dense vegetation limits the inspector's visibility to identify signs of pipe failure (leaks) along the waterward slope. Recommend removing vegetation along pipe alignment to conduct proper inspection of structure. FIELD_STRUCT_DESC: 24-inch CM pipe through levee, 10.5 feet below crown. Flap gate on the waterward end. (USACE-1967). This entry matches the Drainage or Irrigation Structure referenced in O&M manual (HLM 0.39). FS Date: 4/18/2014

View of waterward side.

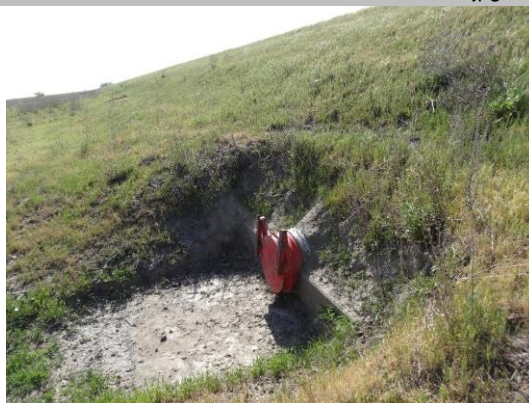
Photo 2 of 3 : UCIP_SP_2017_36704_66649.jpg

FS_ID:36704
DS_ID:19855
EP_NO: N/A
Repair Type: Non-Urgent
Crossing Status: Found
UCIP Comments: Need to contact owner. Dense vegetation limits the inspector's visibility to identify signs of pipe failure (leaks) along the waterward slope. Recommend removing vegetation along pipe alignment to conduct proper inspection of structure.
FIELD_STRUCT_DESC: 24-inch CM pipe through levee, 10.5 feet below crown. Flap gate on the waterward end. (USACE-1967). This entry matches the Drainage or Irrigation Structure referenced in O&M manual (HLM 0.39).
FS Date: 4/18/2014

Concrete headwall and flap gate visible on waterward side.

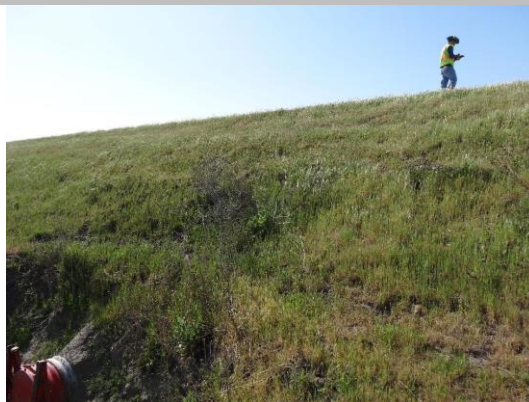
Photo 3 of 3 : UCIP_SP_2017_36704_66648.jpg

View of waterward side--medium grass throughout slope.

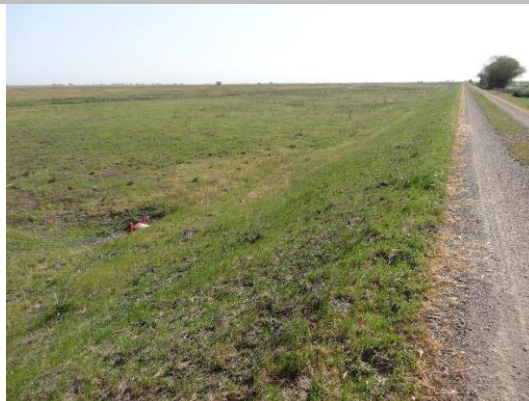
Photo 1 of 3 : UCIP_SP_2017_39889_62048.jpg

LM Start	1.06	Rating **	M	Issue No.	14
LM End	1.06	Issue Type +	Ma	Location *	WS
Category	Supplemental			GPS Latitude/Longitude	
				Start	End
Item	DWR UCIP LMA Responsibility			37.200922 °	37.200922 °
				-120.736012 °	-120.736012 °
DWR ID					
Comment Code					
Inspector Comment					
FS_ID:39889					
DS_ID:19856					
EP_NO: N/A					
Repair Type: Non-Urgent					
Crossing Status: Found					
UCIP Comments: Need to contact owner. Recommend clearing sediment deposit inside pipe.					
FIELD_STRUCT_DESC: 24-inch CM pipe through levee, 10.5 feet below crown. Flap gate on the waterward end. (USACE-1967). This entry matches the Drainage or Irrigation Structure referenced in O&M manual (HLM 1.06).					
FS Date: 4/18/2014

View of waterward side.

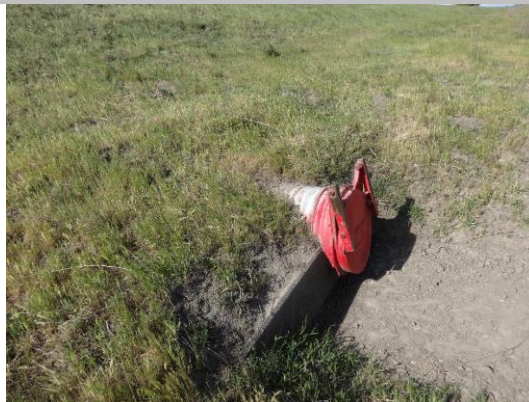
Photo 2 of 3 : UCIP_SP_2017_39889_62049.jpg

Concrete headwall and flap gate visible on waterward side.

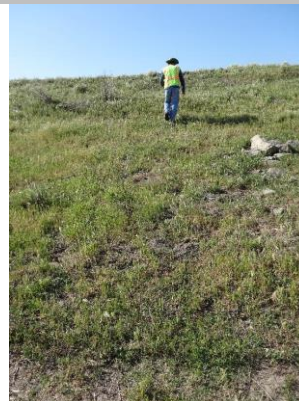
Photo 2 of 3 : UCIP_SP_2017_36705_66652.jpg

Comment Code						
Inspector Comment						
FS_ID:36705 DS_ID:19857 EP_NO: N/A Repair Type: Non-Urgent Crossing Status: Found UCIP Comments: Landward side not accessible due to dense vegetation and fence. Concrete headwall and flap gate under water therefore not able to evaluate condition. Will need to coordinate with owner to evaluate condition of crossing on waterward side and obtain access to evaluate landward side. FIELD_STRUCT_DESC: 24-inch CM pipe through levee, 17.4 feet below crown. Flap gate on the waterward end. (USACE-1967). This entry matches the Drainage or Irrigation Structure referenced in O&M manual (HLM 1.27). FS Date: 4/18/2014

View of waterward slope.

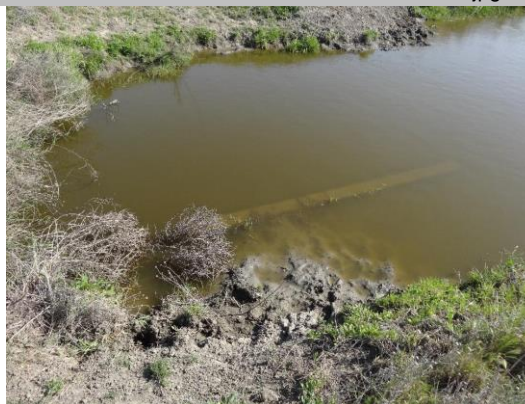
Photo 3 of 3 : UCIP_SP_2017_36705_66653.jpg

View of concrete wall underwater.

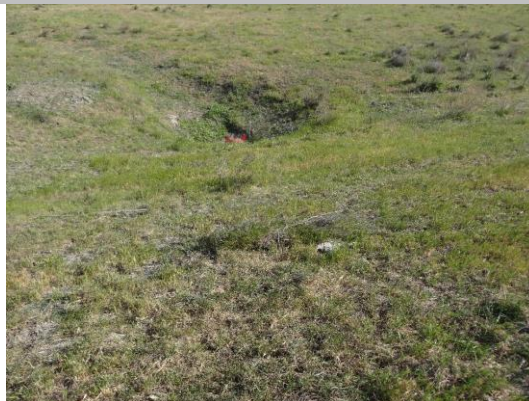
Photo 1 of 3 : UCIP_SP_2017_34126_62060.jpg

LM Start	1.53	Rating **	M	Issue No.	16
LM End	1.53	Issue Type +	Ma	Location *	WS
Category	Supplemental			GPS Latitude/Longitude	
				Start	End
Item	DWR UCIP LMA Responsibility			37.200913 °	37.200913 °
				-120.727496 °	-120.727496 °
DWR ID					
Comment Code					
Inspector Comment					
FS_ID:34126 DS_ID:19858 EP_NO: N/A Repair Type: Non-Urgent Crossing Status: Found UCIP Comments: Limited access on landward side due to fence and dense vegetation. Recommend obtaining access to landward side and clear vegetation on landward side. FIELD_STRUCT_DESC: 24-inch CM pipe through levee, 10.7 feet below crown. Flap gate on the waterward end. (USACE-1967). This entry matches the Drainage or Irrigation Structure referenced in O&M manual (HLM 1.53). FS Date: 4/18/2014

View of waterward side.

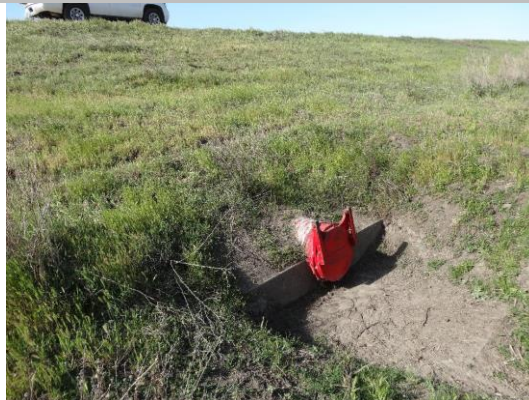
Photo 2 of 3 : UCIP_SP_2017_34126_62061.jpg

Concrete headwall and flap gate visible on waterward side.

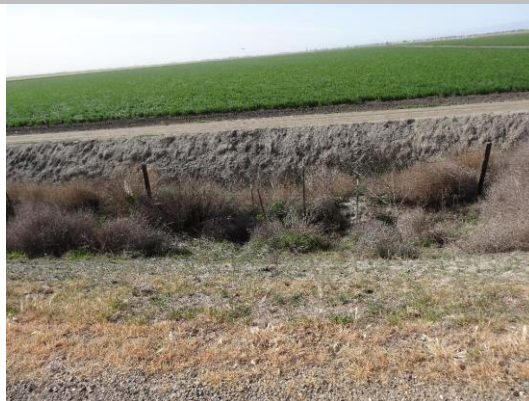
Photo 3 of 3 : UCIP_SP_2017_34126_62059.jpg

View of landward side--limited access due to fence.

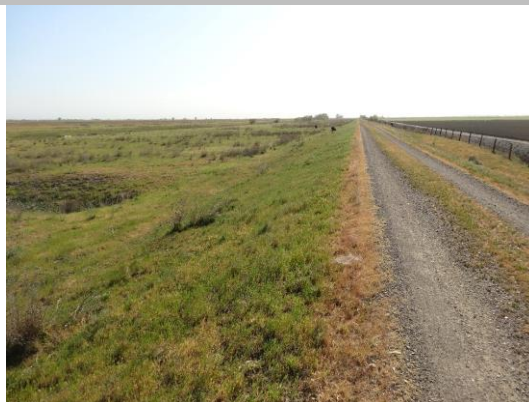
Photo 1 of 3 : UCIP_SP_2017_39506_62064.jpg

LM Start	2.16	Rating **	M	Issue No.	17
LM End	2.16	Issue Type +	Ma	Location *	WS
Category	Supplemental			GPS Latitude/Longitude	
				Start	End
Item	DWR UCIP LMA Responsibility			37.200908 °	37.200908 °
				-120.716118 °	-120.716118 °
DWR ID					
Comment Code					
Inspector Comment					
FS_ID:39506					
DS_ID:19859					
EP_NO: N/A					
Repair Type: Non-Urgent					
Crossing Status: Found					
UCIP Comments: Need to contact owner. Recommend clearing vegetation from landward side--headwall blocked.					
FIELD_STRUCT_DESC: 24-inch CM pipe through levee, 14.4 feet below crown. Flap gate on the waterward end. (USACE-1967). This entry matches the Drainage or Irrigation Structure referenced in O&M manual (HLM 2.16).					
FS Date: 4/18/2014

View of waterward side.

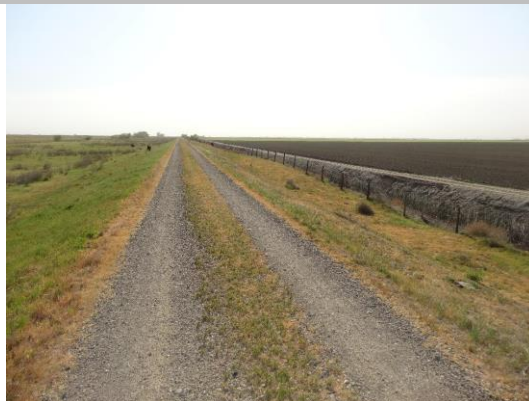
Photo 2 of 3 : UCIP_SP_2017_39506_62063.jpg

Overview of levee crown at crossing.

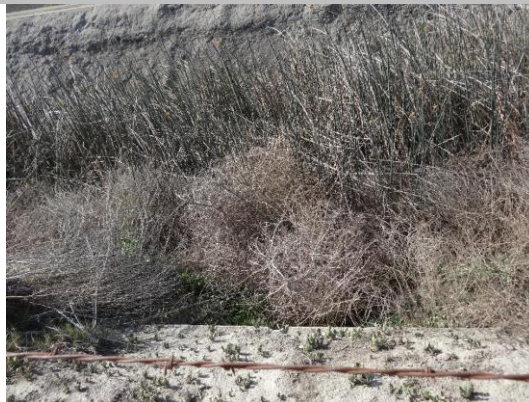
Photo 3 of 3 : UCIP_SP_2017_39506_62062.jpg

Dense vegetation on landward side--limited access due to fence along landward side.

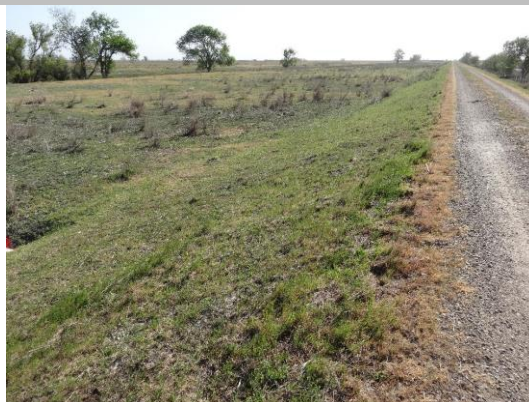
Photo 1 of 3 : UCIP_SP_2017_39890_62069.jpg

LM Start	2.70	Rating **	M	Issue No.	18
LM End	2.70	Issue Type +	Ma	Location *	LS
Category	Supplemental			GPS Latitude/Longitude	
				Start	End
Item	DWR UCIP LMA Responsibility			37.200906 °	37.200906 °
				-120.706316 °	-120.706316 °
DWR ID					
Comment Code					
Inspector Comment					
FS_ID:39890					
DS_ID:19860					
EP_NO: N/A					
Repair Type: Non-Urgent					
Crossing Status: Found					
UCIP Comments: Need to contact owner. Recommend clearing sediment deposit inside pipe.					
FIELD_STRUCT_DESC: 24-inch CM pipe through levee, 10.7 feet below crown. Flap gate on the waterward end. (USACE-1967). This entry matches the Drainage or Irrigation Structure referenced in O&M manual (HLM 2.70).					
FS Date: 4/18/2014

View of waterward side.

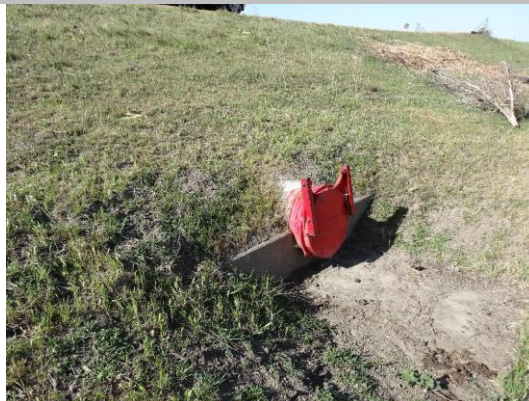
Photo 2 of 3 : UCIP_SP_2017_39890_62070.jpg

LM Start	2.70	Rating **	M	Issue No.	18 (cont)
LM End	2.70	Issue Type +	Ma	Location *	LS
Category	Supplemental			GPS Latitude/Longitude	
				Start	End
Item	DWR UCIP LMA Responsibility			37.200906 °	37.200906 °
				-120.706316 °	-120.706316 °
DWR ID					
Comment Code					
Inspector Comment					
FS_ID:39890 DS_ID:19860 EP_NO: N/A Repair Type: Non-Urgent Crossing Status: Found UCIP Comments: Need to contact owner. Recommend clearing sediment deposit inside pipe. FIELD_STRUCT_DESC: 24-inch CM pipe through levee, 10.7 feet below crown. Flap gate on the waterward end. (USACE-1967). This entry matches the Drainage or Irrigation Structure referenced in O&M manual (HLM 2.70). FS Date: 4/18/2014

Concrete headwall and flat gate located on waterward side.

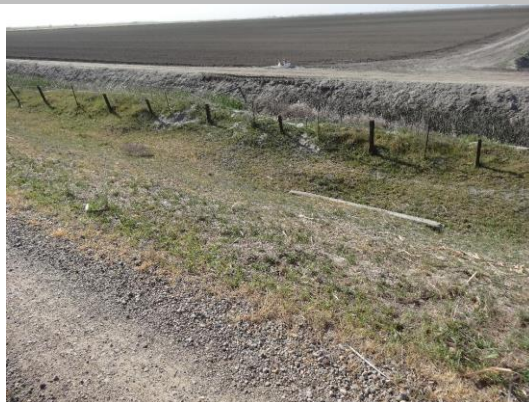
Photo 3 of 3 : UCIP_SP_2017_39890_62068.jpg

View of landward side.

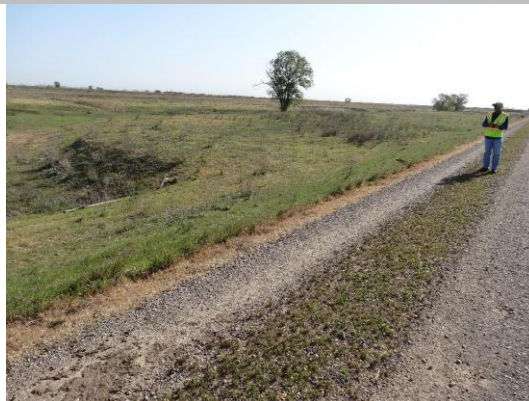
Photo 1 of 3 : UCIP_SP_2017_46786_62073.jpg

View of waterward side.

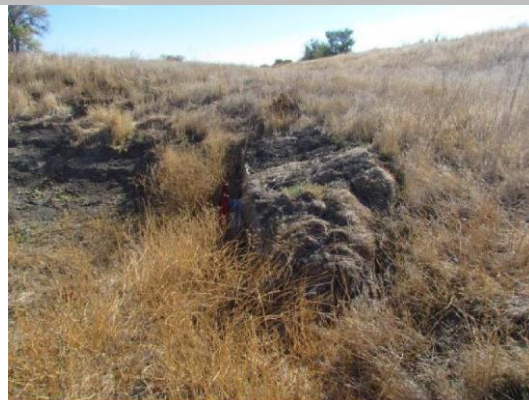
Photo 2 of 3 : UCIP_SP_2017_46786_74729.jpg

Repair to headwall located on waterward side has been addressed.

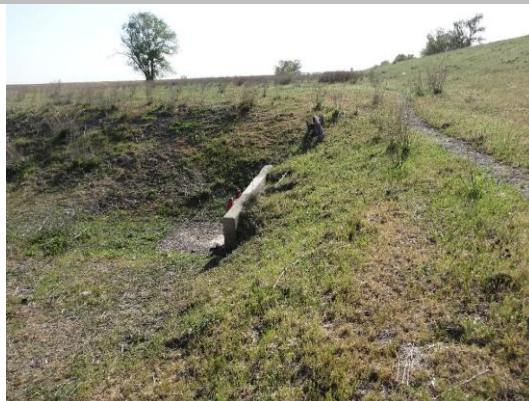
Photo 3 of 3 : UCIP_SP_2017_46786_62072.jpg

FS_ID:46786
DS_ID:19861
EP_NO: N/A
Repair Type: Non-Urgent
Crossing Status: Found
UCIP Comments: 11-09-2015 DWR Inspection section confirmed issue has been addressed. Need to coordinate with LMA to determine additional details for extent of repair. 10-18-2014 Soil missing behind concrete headwall on waterward side. Unable to determine if missing soil is due to sink holes, rodent activity, or due to erosion. Headwall appears to be leaning slightly forward. Reason why this crossing was labelled urgent was due to the uncertainty of damage to concrete headwall and reason for soil missing behind concrete. Need to coordinate with LMA to determine more information about repair at this location.
FIELD_STRUCT_DESC: 24-inch CM pipe through levee, 2 feet below levee crown. Flap gate on the waterward end. (USACE-1967). This entry matches the Drainage or Irrigation Structure referenced in O&M manual (HLM 3.00).

Side view of concrete headwall which appears to be slightly slanted forward--missing soil behind headwall.

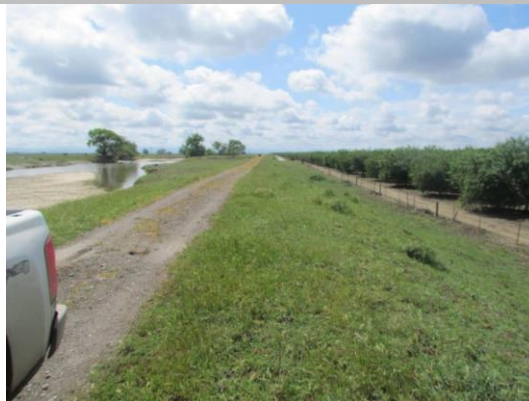
Photo 1 of 1 : SP_2017_NA0010_131_7_20170425_00017.jpg

LM Start	0.02	Rating **	M	Issue No.	7
LM End	1.26	Issue Type +	Ma	Location *	LS
Category	Earthen Levee			GPS Latitude/Longitude	
				Start	End
Item	Vegetation			37.034032 °	37.046342 °
				-120.441967 °	-120.428060 °
DWR ID	DWR_NA0010_13_s_2017_7				
Comment Code					
V1 : Control annual grass and weeds on the levee slopes and easements.					
Inspector Comment

Looking at typical view of landward slope.

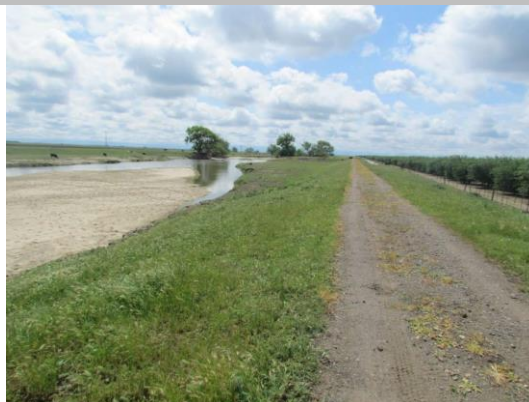
Photo 1 of 1 : SP_2017_NA0010_131_8_20170425_00016.jpg

LM Start	0.02	Rating **	M	Issue No.	8	
LM End	1.26	Issue Type +	Ma	Location *	WS	
Category	Earthen Levee			GPS Latitude/Longitude		
				Start		End
Item	Vegetation			37.034032 °		37.046342 °
				-120.441967 °		-120.428060 °
DWR ID	DWR_NA0010_13_s_2017_8					
Comment Code						
V1 : Control annual grass and weeds on the levee slopes and easements.						
Inspector Comment

Looking at typical view of waterward slope.

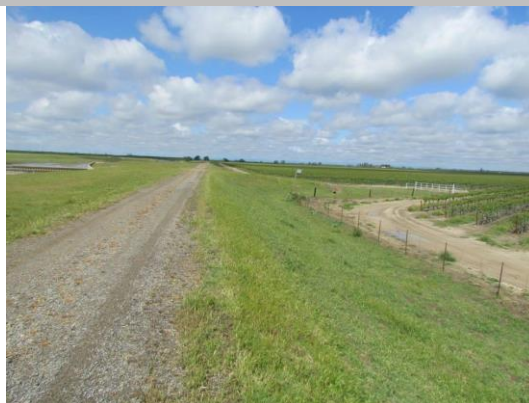
Photo 1 of 1 : SP_2017_NA0010_132_4_20170425_00009.jpg

LM Start	0.00	Rating **	M	Issue No.	4
LM End	1.26	Issue Type +	Ma	Location *	LS
Category	Earthen Levee			GPS Latitude/Longitude	
				Start	End
Item	Vegetation			37.032290 °	37.045455 °
				-120.441275 °	-120.427673 °
DWR ID	DWR_NA0010_14_s_2017_4				
Comment Code					
V1 : Control annual grass and weeds on the levee slopes and easements.					
Inspector Comment

Looking at typical view of landward slope.

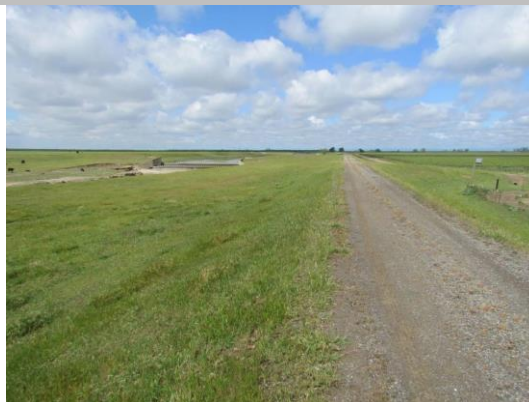
Photo 1 of 1 : SP_2017_NA0010_132_5_20170425_00010.jpg

LM Start	0.00	Rating **	M	Issue No.	5
LM End	1.26	Issue Type +	Ma	Location *	WS
Category	Earthen Levee			GPS Latitude/Longitude	
				Start	End
Item	Vegetation			37.032290 °	37.045455 °
				-120.441275 °	-120.427673 °
DWR ID	DWR_NA0010_14_s_2017_5				
Comment Code					
V1 : Control annual grass and weeds on the levee slopes and easements.					
Inspector Comment

Looking at typical view of waterward slope.

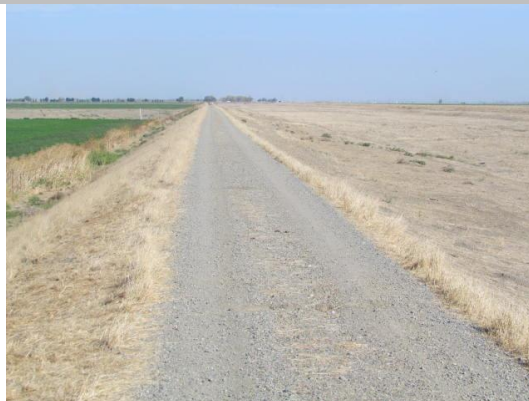
Photo 1 of 1 : SP_2017_NA0010_132_2_20170417_00001.jpg

LM Start	0.00	Rating **	M	Issue No.	2
LM End	1.26	Issue Type +	Ma	Location *	CR
Category	Earthen Levee			GPS Latitude/Longitude	
				Start	End
Item	Crown Surface / Depressions / Rutting			37.032379 °	37.045404 °
				-120.441265 °	-120.427749 °
DWR ID	DWR_NA0010_14_f_2012_2				
Comment Code					
C3 : Add appropriate gravel or road base. Grade and compact.					
Inspector Comment					
Control vegetation on levee crown.

Looking at typical view of levee crown.

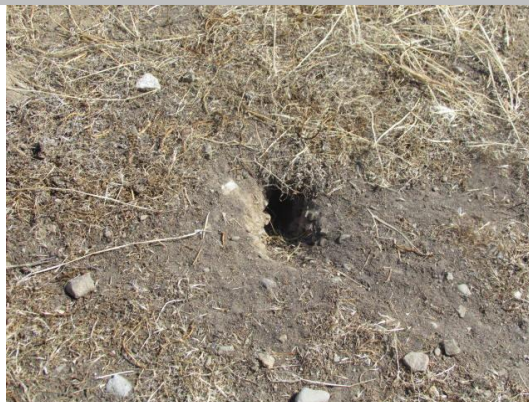
Photo 1 of 1 : SP_2017_NA0010_132_79_20170417_00002.jpg

LM Start	1.24	Rating **	M	Issue No.	79
LM End	1.24	Issue Type +	Ma	Location *	LS
Category	Earthen Levee			GPS Latitude/Longitude	
				Start	End
Item	Animal Control			37.045343 °	37.045343 °
				-120.428007 °	-120.428007 °
DWR ID	DWR_NA0010_14_s_2015_79				
Comment Code					
A3 : No rodents visible, but rodent burrows visible; need to backfill and compact or grout burrows.					
Inspector Comment					
Noted several rodent holes on landward at this location.

Looking at typical view of rodent holes on landward slope.

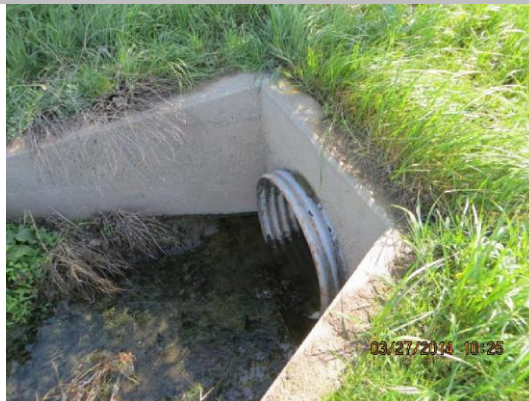
Photo 1 of 3 : UCIP_SP_2017_32828_59402.jpg

Concrete U-shaped headwall on Ws toe.

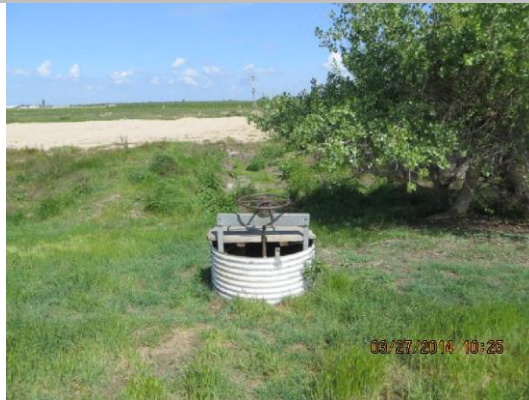
Photo 2 of 3 : UCIP_SP_2017_32828_59401.jpg

slidegate in CMP riser on WS slope.

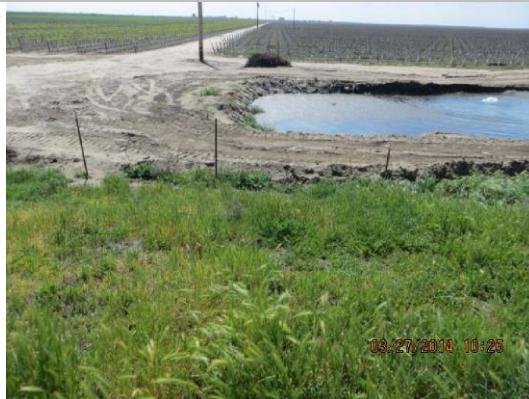
Photo 3 of 3 : UCIP_SP_2017_32828_59400.jpg

Inlet assumed to be within irrigation structure off LS toe.

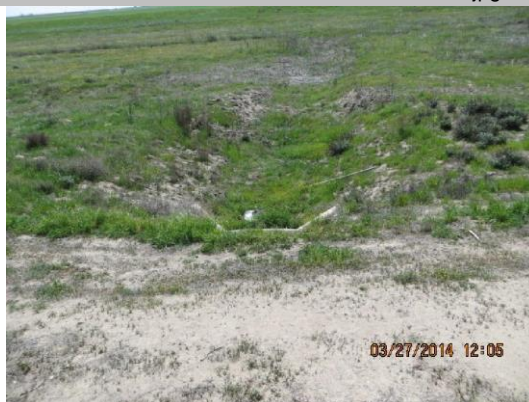
Photo 1 of 3 : UCIP_SP_2017_32838_59448.jpg

Concrete headwall on WS toe.

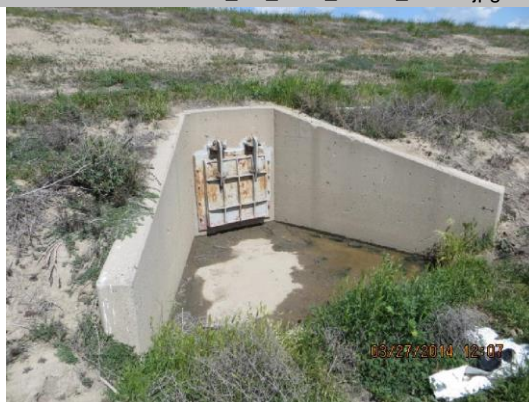
Photo 2 of 3 : UCIP_SP_2017_32838_59449.jpg

Flapgate on Concrete headwall at WS toe.

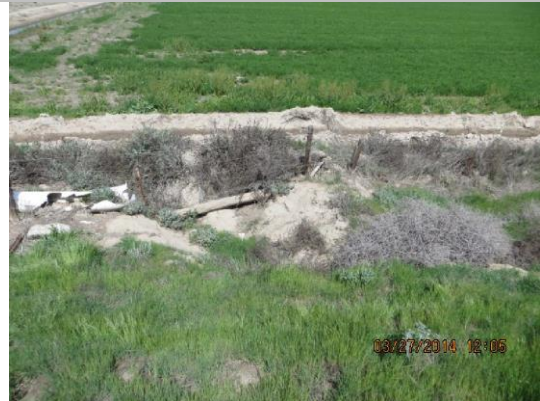
Photo 3 of 3 : UCIP_SP_2017_32838_59447.jpg

Concrete headwall on LS toe.

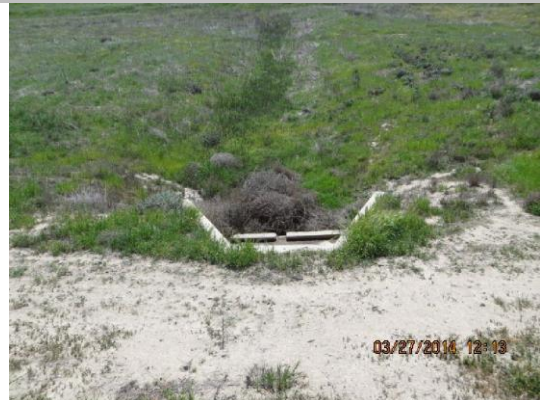
Photo 1 of 3 : UCIP_SP_2017_39527_59452.jpg

Comment Code					
Inspector Comment					
FS_ID:39527					
DS_ID:19912					
EP_NO: N/A					
Repair Type: Non-Urgent					
Crossing Status: Found					
UCIP Comments: Dense vegetation limits the inspector's visibility to identify signs of pipe failure (leaks) along the landward slope.					
Recommend removing vegetation along pipe alignment to conduct proper inspection of structure.					
FIELD_STRUCT_DESC: 30-inch square R.C.B.C. through the levee, 8.5 feet below the crown. Concrete "U" headwall on the waterward end.					
Flap gate on the waterward end. Concrete headwall on the landward end. (USACE-1967). This entry matches the Drainage or Irrigation Structure referenced in O&M manual (HLM 1.01).					
FS Date: 3/27/2014

Concrete headwall on WS toe.

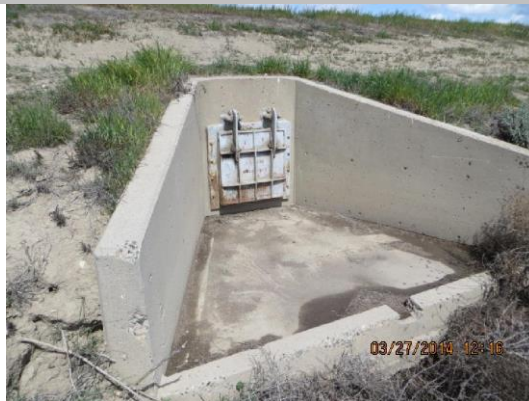
Photo 2 of 3 : UCIP_SP_2017_39527_59453.jpg

Flapgate on concrete headwall at WS toe.

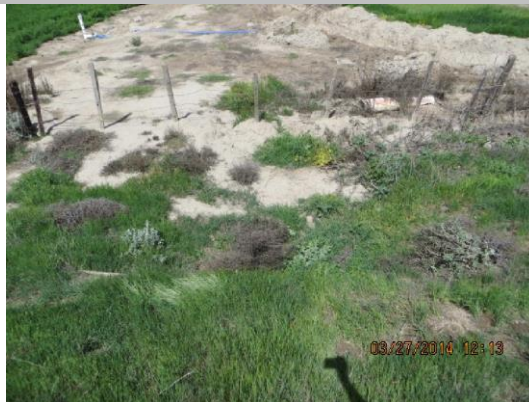
Photo 3 of 3 : UCIP_SP_2017_39527_59451.jpg

Concrete headwall on LS toe.

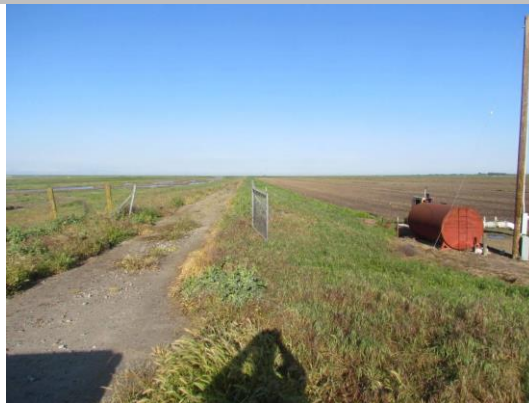
Photo 1 of 1 : SP_2017_NA0010_133_7_20170425_00014.jpg

LM Start	1.51	Rating **	U	Issue No.	7
LM End	2.03	Issue Type +	Ma	Location *	LS
Category	Earthen Levee			GPS Latitude/Longitude	
				Start	End
Item	Vegetation			36.996602 °	36.996577 °
				-120.383125 °	-120.373762 °
DWR ID	DWR_NA0010_15_s_2017_7				
Comment Code					
V2 : Remove the wild growth other than native grasses from the levee slopes.					
Inspector Comment

Looking downstream at dense veg on landward slope.

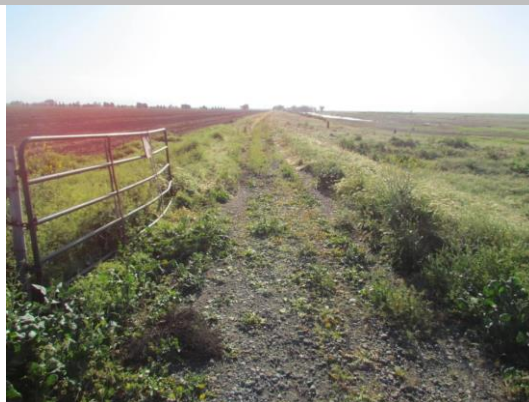
Photo 1 of 1 : SP_2017_NA0010_133_8_20170425_00013.jpg

LM Start	1.51	Rating **	U	Issue No.	8
LM End	2.03	Issue Type +	Ma	Location *	WS
Category	Earthen Levee			GPS Latitude/Longitude	
				Start	End
Item	Vegetation			36.996602 °	36.996577 °
				-120.383125 °	-120.373762 °
DWR ID	DWR_NA0010_15_s_2017_8				
Comment Code					
V2 : Remove the wild growth other than native grasses from the levee slopes.					
Inspector Comment

Looking upstream at dense veg on waterward slope.

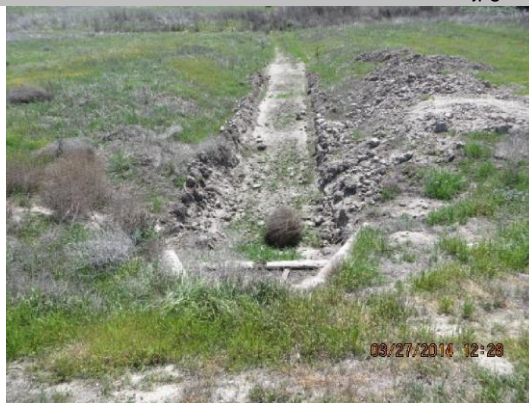
Photo 1 of 3 : UCIP_SP_2017_32840_59456.jpg

Concrete headwall on WS toe.

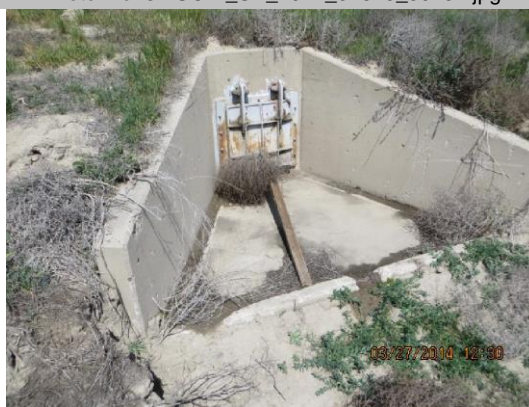
Photo 2 of 3 : UCIP_SP_2017_32840_59457.jpg

Flapgate on concrete headwall at WS toe.

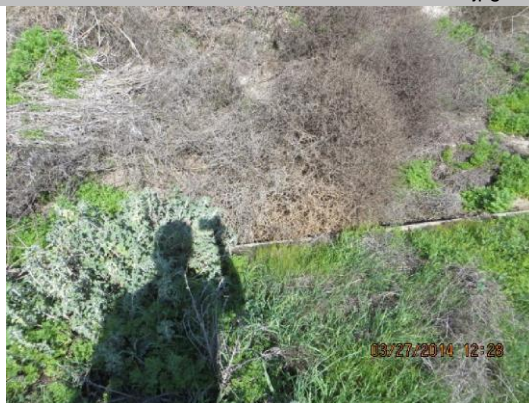
Photo 3 of 3 : UCIP_SP_2017_32840_59455.jpg

Concrete headwall on LS toe. Note excessive vegetation buildup.

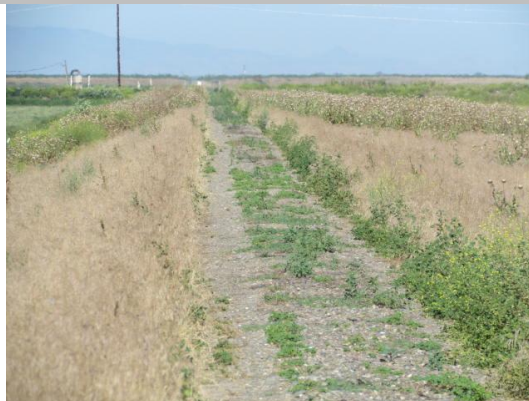
Photo 1 of 1 : SP_2017_NA0010_134_14_20170417_00004.jpg

LM Start	0.01	Rating **	M	Issue No.	14
LM End	1.96	Issue Type +	Ma	Location *	CR
Category	Earthen Levee			GPS Latitude/Longitude	
				Start	End
Item	Crown Surface / Depressions / Rutting			36.995388 °	36.995507 °
				-120.408738 °	-120.373592 °
DWR ID	DWR_NA0010_16_s_2012_14				
Comment Code					
C1 : Add appropriate material and re-grade the levee to bring the crown above the design elevation.					
Inspector Comment					
Control vegetation and regrade levee crown.

Looking at typical view of levee crown.

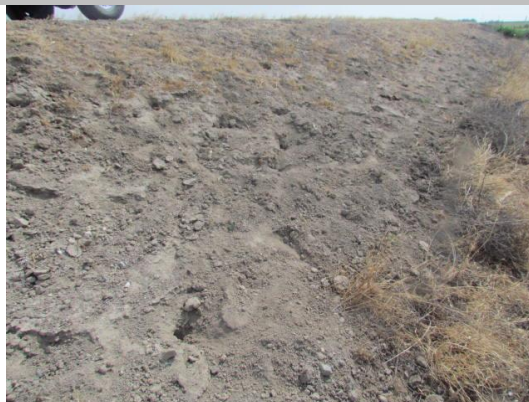
Photo 1 of 1 : SP_2017_NA0010_134_92_20170417_00005.jpg

LM Start	0.93	Rating **	M	Issue No.	92
LM End	0.93	Issue Type +	Ma	Location *	LS
Category	Earthen Levee			GPS Latitude/Longitude	
				Start	End
Item	Animal Control			36.995439 °	36.995439 °
				-120.392146 °	-120.392146 °
DWR ID	DWR_NA0010_16_s_2015_92				
Comment Code					
A3 : No rodents visible, but rodent burrows visible; need to backfill and compact or grout burrows.					
Inspector Comment					
Notice several rodent holes within this section.

Looking at several rodent holes on landward slope.

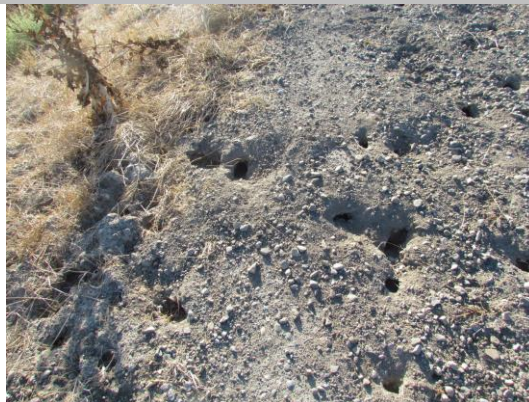
Photo 1 of 1 : SP_2017_NA0010_134_3_20170417_00003.jpg

LM Start	1.09	Rating **	U	Issue No.	3
LM End	1.09	Issue Type +	Ma	Location *	CR
Category	Earthen Levee			GPS Latitude/Longitude	
				Start	End
Item	Animal Control			36.995433 °	36.995433 °
				-120.389190 °	-120.389190 °
DWR ID	DWR_NA0010_16_f_2016_3				
Comment Code					
Inspector Comment					
Notice several rodent holes on levee crown.

Looking at several rodent holes and moles holes on levee crown.
