**Flood Control Project Maintenance
Levee Inspections**

Maintenance Issue Types Only, Levee Inspection Report By Mile - Spring 2017

Lower San Joaquin Levee District

Waterway	Bank	Unit Miles	Inspection Start/End	Inspector
Unit No. 01 San Joaquin River	Right	22.52	04/17/2017 04/20/2017	Richard Willoughby

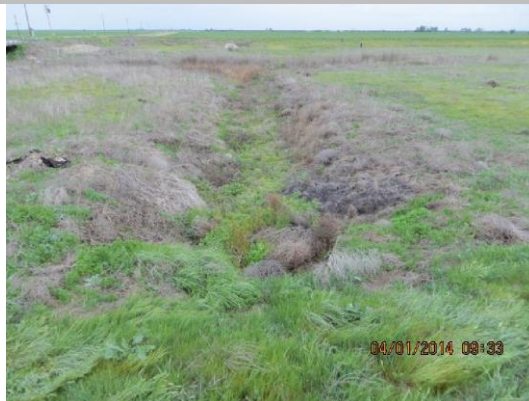
Photo 1 of 3 : UCIP_SP_2017_39529_59681.jpg

LM Start	1.44	Rating **	M	Issue No.	93
LM End	1.44	Issue Type +	Ma	Location *	LS
Category	Supplemental			GPS Latitude/Longitude	
				Start	End
Item	DWR UCIP LMA Responsibility			36.995473 °	36.995473 °
				-120.382872 °	-120.382872 °
DWR ID					
Comment Code					
Inspector Comment					
FS_ID:39529 DS_ID:19915 EP_NO: N/A Repair Type: Non-Urgent Crossing Status: Found UCIP Comments: Dense vegetation buildup at landside toe-- recommend clearing. FIELD_STRUCT_DESC: 30-inch square R.C.B.C. through levee, 8.5 feet below crown. Concrete "U" headwall on waterward end. Two concrete cutoff walls. Flap gate on waterward side. Concrete headwall on landward end. (USACE-1967). This entry matches the Drainage or Irrigation Structure referenced in O&M manual (HLM 1.46). FS Date: 4/1/2014 8:12:00 AM

Concrete headwall on WS toe with channel.

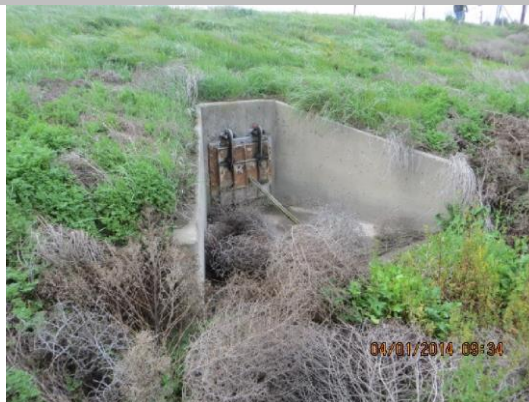
Photo 2 of 3 : UCIP_SP_2017_39529_59680.jpg

Flapgate on headwall at WS toe.

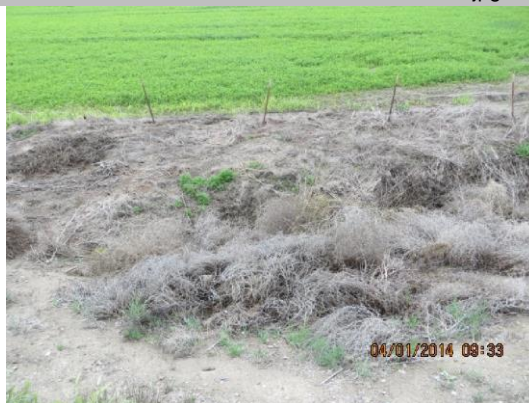
Photo 3 of 3 : UCIP_SP_2017_39529_59682.jpg

LM Start	1.44	Rating **	M	Issue No.	93 (cont)	
LM End	1.44	Issue Type +	Ma	Location *	LS	
Category	Supplemental			GPS Latitude/Longitude		
				Start		End
Item	DWR UCIP LMA Responsibility			36.995473 °		36.995473 °
				-120.382872 °		-120.382872 °
DWR ID						
Comment Code						
Inspector Comment						
FS_ID:39529 DS_ID:19915 EP_NO: N/A Repair Type: Non-Urgent Crossing Status: Found UCIP Comments: Dense vegetation buildup at landside toe-- recommend clearing. FIELD_STRUCT_DESC: 30-inch square R.C.B.C. through levee, 8.5 feet below crown. Concrete "U" headwall on waterward end. Two concrete cutoff walls. Flap gate on waterward side. Concrete headwall on landward end. (USACE-1967). This entry matches the Drainage or Irrigation Structure referenced in O&M manual (HLM 1.46). FS Date: 4/1/2014 8:12:00 AM

Concrete headwall on LS toe covered in vegetation/tumble weeds.

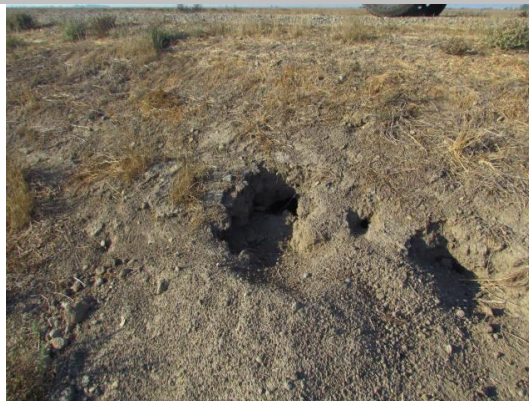
Photo 1 of 2 : SP_2017_NA0010_134_2_20170417_00001.jpg

LM Start	1.77	Rating **	U	Issue No.	2 (cont)
LM End	1.77	Issue Type +	Ma	Location *	LS

Looking at large rodent holes on landward slope.

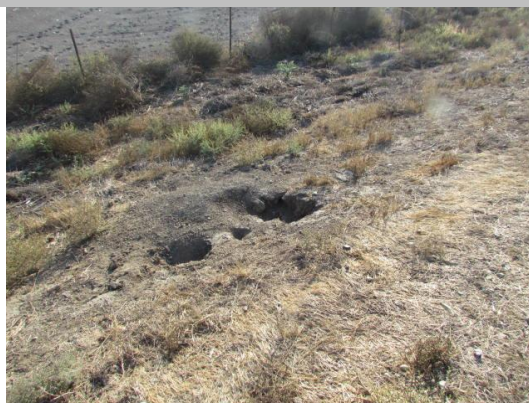
Photo 2 of 2 : SP_2017_NA0010_134_2_20170417_00002.jpg

Looking southwest at several rodent holes on landward slope.

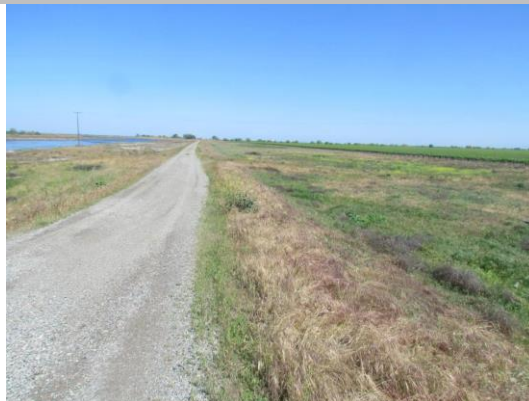
Photo 1 of 1 : SP_2017_NA0010_135_11_20170425_00034.jpg

LM Start	0.00	Rating **	M	Issue No.	11
LM End	16.09	Issue Type +	Ma	Location *	LS
Category	Earthen Levee			GPS Latitude/Longitude	
				Start	End
Item	Vegetation			36.976445 °	36.774417 °
				-120.374700 °	-120.283748 °
DWR ID	DWR_NA0010_17_f_2016_11				
Comment Code					
V1 : Control annual grass and weeds on the levee slopes and easements.					
Inspector Comment					
Dense vegetation (tumble weeds) on levee slope.

Looking at typical view of landward slope.

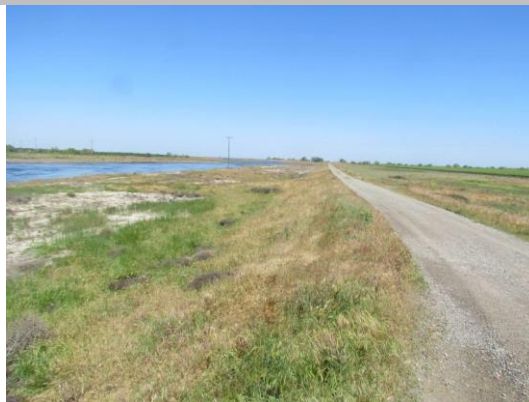
Photo 1 of 1 : SP_2017_NA0010_135_12_20170425_00033.jpg

LM Start	0.00	Rating **	M	Issue No.	12
LM End	16.09	Issue Type +	Ma	Location *	WS
Category	Earthen Levee			GPS Latitude/Longitude	
				Start	End
Item	Vegetation			36.976445 °	36.774417 °
				-120.374700 °	-120.283748 °
DWR ID	DWR_NA0010_17_f_2016_12				
Comment Code					
V1 : Control annual grass and weeds on the levee slopes and easements.					
Inspector Comment					
Dense vegetation (Tumble weeds) on levee slope.

Looking at typical view of waterward slope.

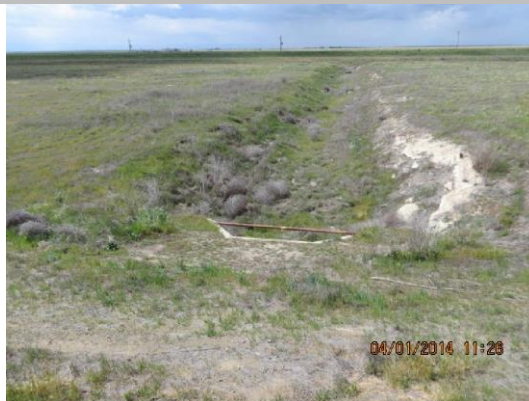
Photo 1 of 3 : UCIP_SP_2017_39531_59710.jpg

FS_ID:39531
DS_ID:19916
EP_NO: N/A
Repair Type: Non-Urgent
Crossing Status: Found
UCIP Comments: Dense vegetation limits the inspector's visibility to identify signs of pipe failure (leaks) along the landward slope. Recommend removing vegetation along pipe alignment to conduct proper inspection of structure.
FIELD_STRUCT_DESC: 48x60-inch R.C.B.C. through the levee, 14.6 feet below the crown. Concrete "U" headwall on the waterward end. Flap gate on the waterward end. Concrete headwall on the landward end. (USACE-1967). This entry matches the Drainage or Irrigation Structure referenced in O&M manual (HLM 2.58).
FS Date: 4/1/2014

Concrete headwall at channel on WS toe.

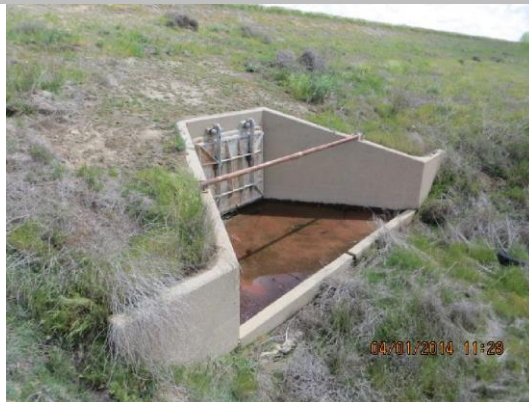
Photo 2 of 3 : UCIP_SP_2017_39531_59711.jpg

Flapgate on Concrete headwall at WS toe.

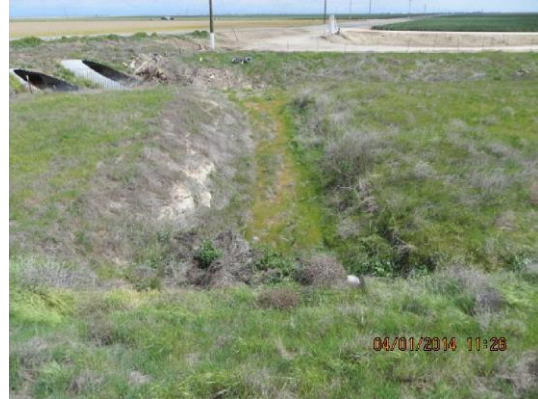
Photo 3 of 3 : UCIP_SP_2017_39531_59709.jpg

Comment Code						
Inspector Comment						
FS_ID:39531						
DS_ID:19916						
EP_NO: N/A						
Repair Type: Non-Urgent						
Crossing Status: Found						
UCIP Comments: Dense vegetation limits the inspector's visibility to identify signs of pipe failure (leaks) along the landward slope.						
Recommend removing vegetation along pipe alignment to conduct proper inspection of structure.						
FIELD_STRUCT_DESC: 48x60-inch R.C.B.C. through the levee, 14.6 feet below the crown. Concrete "U" headwall on the waterward end.						
Flap gate on the waterward end. Concrete headwall on the landward end. (USACE-1967). This entry matches the Drainage or Irrigation Structure referenced in O&M manual (HLM 2.58).						
FS Date: 4/1/2014

Concrete headwall at LS toe.

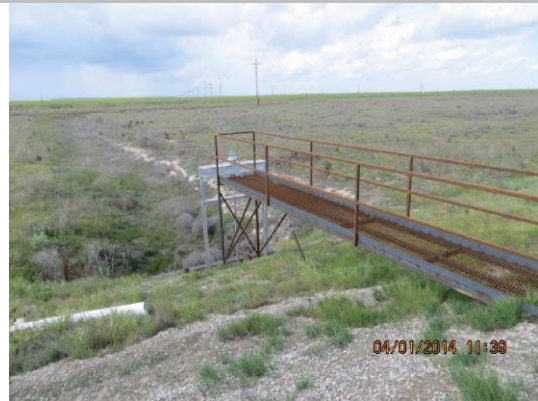
Photo 1 of 3 : UCIP_SP_2017_32998_59714.jpg

LM Start	4.68	Rating **	A/W	Issue No.	14
LM End	4.68	Issue Type +	Ma	Location *	WS
Category	Supplemental			GPS Latitude/Longitude	
				Start	End
Item	DWR UCIP LMA Responsibility			36.923426 °	36.923426 °
				-120.336559 °	-120.336559 °
DWR ID					
Comment Code					
Inspector Comment					
FS_ID:32998 DS_ID:19921 EP_NO: N/A Repair Type: No Action Needed Crossing Status: Found UCIP Comments: FIELD_STRUCT_DESC: 48x60-inch R.C.B.C. through the levee, 14.6 feet below the crown. Concrete "U" headwall on the waterward end. 36-inch weir structure on waterward side. Combination Flap gate/slidebar gate on the waterward toe (USACE-1967). Steel walkway to slide gate actuator on WS shoulder. This entry matches the Drainage or Irrigation Structure referenced in O&M manual (HLM 4.69). Cable winch, weir structure and external drainage system built under Permit No. 13587 (1984). FS Date: 4/1/2014

Steel walkway to slide gate actuator on WS shoulder.

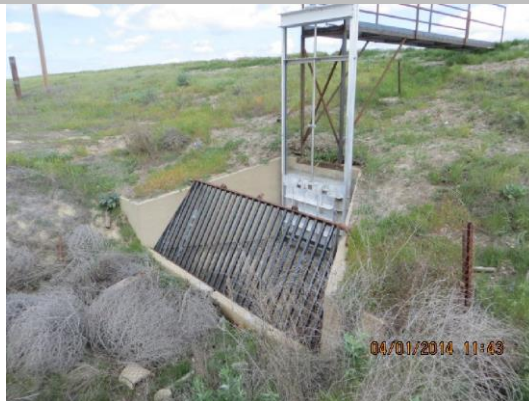
Photo 2 of 3 : UCIP_SP_2017_32998_59715.jpg

Item	DWR UCIP LMA Responsibility			36.923426 °		36.923426 °
				-120.336559 °		-120.336559 °
DWR ID						
Comment Code						
Inspector Comment						
FS_ID:32998 DS_ID:19921 EP_NO: N/A Repair Type: No Action Needed Crossing Status: Found UCIP Comments: FIELD_STRUCT_DESC: 48x60-inch R.C.B.C. through the levee, 14.6 feet below the crown. Concrete "U" headwall on the waterward end. 36-inch weir structure on waterward side. Combination Flap gate/slidegate on the waterward toe (USACE-1967). Steel walkway to slide gate actuator on WS shoulder. This entry matches the Drainage or Irrigation Structure referenced in O&M manual (HLM 4.69). Cable winch, weir structure and external drainage system built under Permit No. 13587 (1984). FS Date: 4/1/2014

Combination flapgate/slidegate, concrete headwall, and metal screen at WS toe.

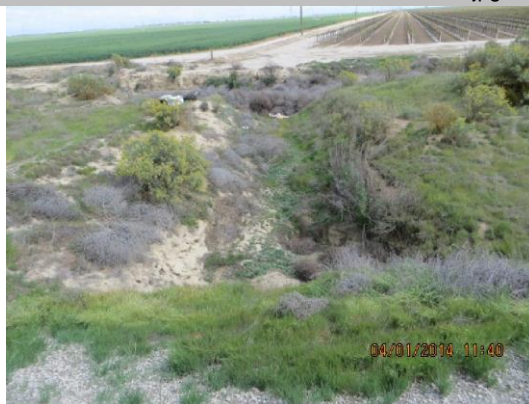
Photo 3 of 3 : UCIP_SP_2017_32998_59713.jpg

Concrete headwall on LS toe.

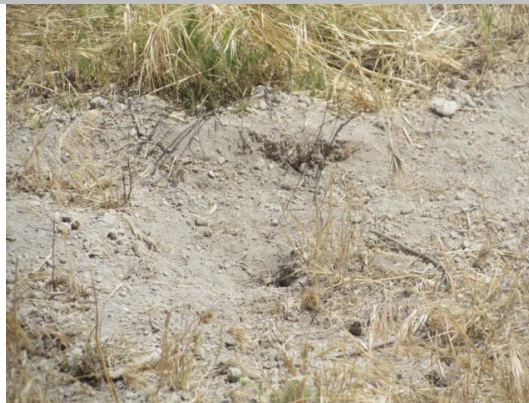
Photo 1 of 1 : SP_2017_NA0010_135_5_20170417_00004.jpg

LM Start	7.27	Rating **	M	Issue No.	5
LM End	7.38	Issue Type +	Ma	Location *	LS
Category	Earthen Levee			GPS Latitude/Longitude	
				Start	End
Item	Animal Control			36.887869 °	36.886341 °
				-120.321697 °	-120.320940 °
DWR ID	DWR_NA0010_17_s_2012_5				
Comment Code					
A3 : No rodents visible, but rodent burrows visible; need to backfill and compact or grout burrows.					
Inspector Comment					
Notice several rodent holes within this reach.

Looking at typical view of rodent holes on landward slope.

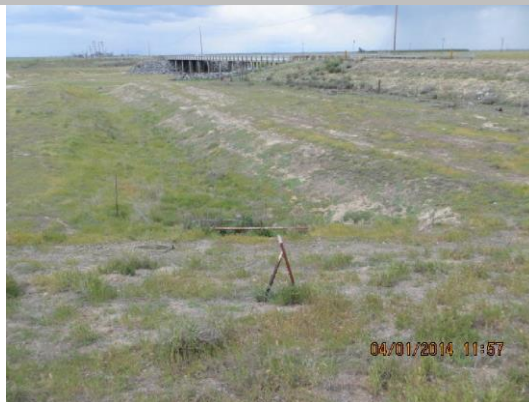
Photo 1 of 3 : UCIP_SP_2017_32999_59718.jpg

LM Start	8.37	Rating **	A/W	Issue No.	15
LM End	8.37	Issue Type +	Ma	Location *	LS
Category	Supplemental			GPS Latitude/Longitude	
				Start	End
Item	DWR UCIP LMA Responsibility			36.872358 °	36.872358 °
				-120.317170 °	-120.317170 °
DWR ID					
Comment Code					
Inspector Comment					
FS_ID:32999					
DS_ID:19922					
EP_NO: N/A					
Repair Type: No Action Needed					
Crossing Status: Found					
UCIP Comments:					
FIELD_STRUCT_DESC: 48x60-inch R.C.B.C. through the levee. 16.5					
feet below the crown. Concrete "U" headwall on the waterward end.					
Flap gate on the waterward end. Concrete headwall on the landward					
end. (USACE-1967). This entry matches the Drainage or Irrigation					
Structure referenced in O&M manual (HLM 8.38).					
FS Date: 4/1/2014

Concrete headwall and channel on WS toe.

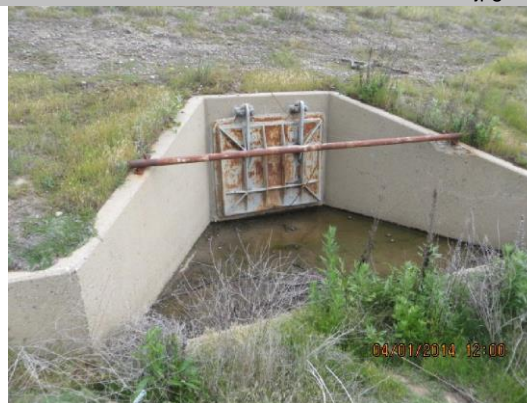
Photo 2 of 3 : UCIP_SP_2017_32999_59720.jpg

LM Start	8.37	Rating **	A/W	Issue No.	15 (cont)
LM End	8.37	Issue Type +	Ma	Location *	LS
Category	Supplemental			GPS Latitude/Longitude	
				Start	End
Item	DWR UCIP LMA Responsibility			36.872358 °	36.872358 °
				-120.317170 °	-120.317170 °
DWR ID					
Comment Code					
Inspector Comment					
FS_ID:32999 DS_ID:19922 EP_NO: N/A Repair Type: No Action Needed Crossing Status: Found UCIP Comments: FIELD_STRUCT_DESC: 48x60-inch R.C.B.C. through the levee. 16.5 feet below the crown. Concrete "U" headwall on the waterward end. Flap gate on the waterward end. Concrete headwall on the landward end. (USACE-1967). This entry matches the Drainage or Irrigation Structure referenced in O&M manual (HLM 8.38). FS Date: 4/1/2014

Flapgate on concrete headwall at WS toe.

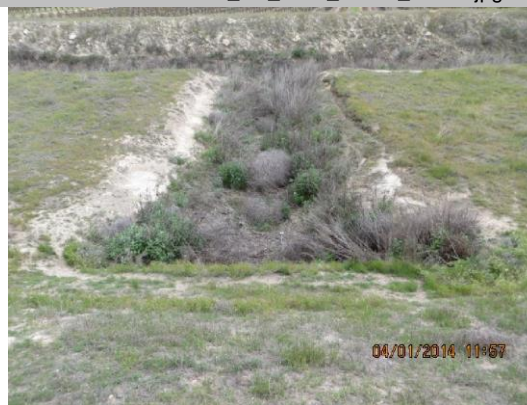
Photo 3 of 3 : UCIP_SP_2017_32999_59719.jpg

Concrete headwall and channel on LS toe.

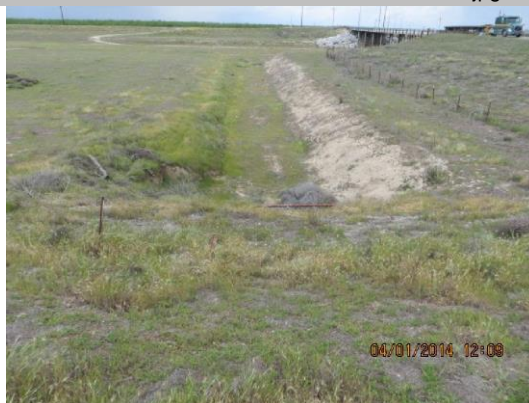
Photo 1 of 3 : UCIP_SP_2017_39532_59723.jpg

LM Start	9.88	Rating **	M	Issue No.	16
LM End	9.88	Issue Type +	Ma	Location *	LS
Category	Supplemental			GPS Latitude/Longitude	
				Start	End
Item	DWR UCIP LMA Responsibility		36.850703 °	36.850703 °	
			-120.314154 °	-120.314154 °	
DWR ID					
Comment Code					
Inspector Comment					
FS_ID:39532 DS_ID:19917 EP_NO: N/A Repair Type: Non-Urgent Crossing Status: Found UCIP Comments: Dense vegetation limits the inspector's visibility to identify signs of pipe failure (leaks) along the landward slope. Recommend removing vegetation along pipe alignment to conduct proper inspection of structure. FIELD_STRUCT_DESC: 48x60-inch R.C.B.C. through the levee, 15-feet below the crown. Concrete "U" headwall on the waterward end. Concrete headwall on landward end. (USACE-1967). This entry matches the Drainage or Irrigation Structure referenced in O&M manual (HLM 9.89). FS Date: 4/1/2014

Concrete headwall and channel on WS toe.

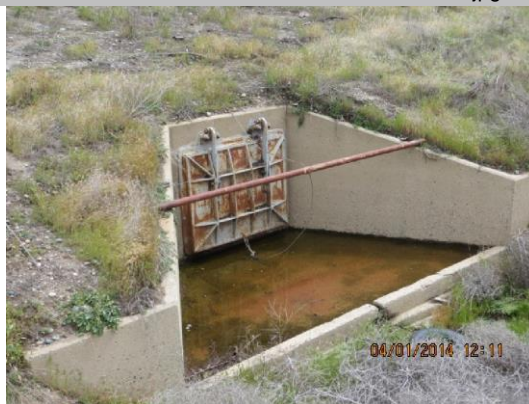
Photo 2 of 3 : UCIP_SP_2017_39532_59724.jpg

Flapgate on Concrete headwall at WS toe.

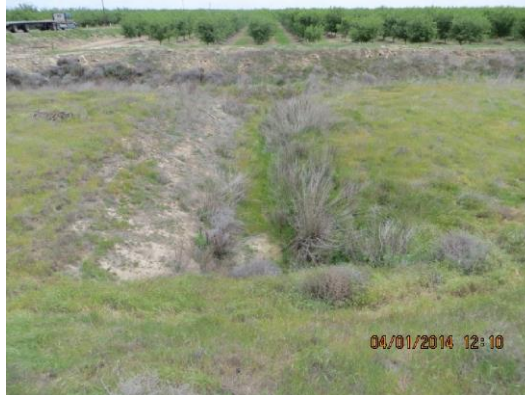
Photo 3 of 3 : UCIP_SP_2017_39532_59722.jpg

Comment Code						
Inspector Comment						
FS_ID:39532 DS_ID:19917 EP_NO: N/A Repair Type: Non-Urgent Crossing Status: Found UCIP Comments: Dense vegetation limits the inspector's visibility to identify signs of pipe failure (leaks) along the landward slope. Recommend removing vegetation along pipe alignment to conduct proper inspection of structure. FIELD_STRUCT_DESC: 48x60-inch R.C.B.C. through the levee, 15-feet below the crown. Concrete "U" headwall on the waterward end. Concrete headwall on landward end. (USACE-1967). This entry matches the Drainage or Irrigation Structure referenced in O&M manual (HLM 9.89). FS Date: 4/1/2014

Concrete headwall and channel on LS toe.

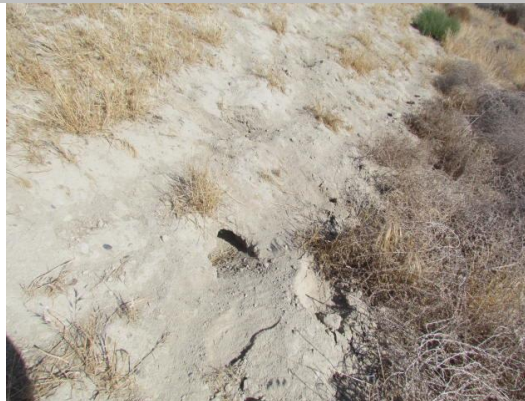
Photo 1 of 2 : SP_2017_NA0010_135_3_20170417_00001.jpg

LM Start	12.34	Rating **	M	Issue No.	3
LM End	12.38	Issue Type +	Ma	Location *	LS
Category	Earthen Levee			GPS Latitude/Longitude	
				Start	End
Item	Animal Control			36.820558 °	36.820000 °
				-120.300616 °	-120.300831 °
DWR ID	DWR_NA0010_17_s_2014_3				
Comment Code					
A3 : No rodents visible, but rodent burrows visible; need to backfill and compact or grout burrows.					
Inspector Comment					
Noted several rodent holes with this reach.

Looking at typical view of rodent holes on landward slope. Fall 2015

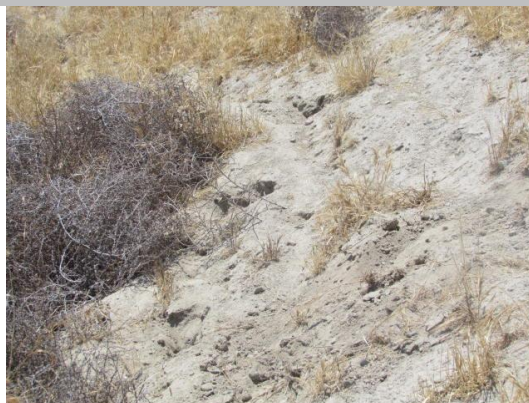
Photo 2 of 2 : SP_2017_NA0010_135_3_20170417_00002.jpg

LM Start	12.34	Rating **	M	Issue No.	3 (cont)	
LM End	12.38	Issue Type +	Ma	Location *	LS	
Category	Earthen Levee			GPS Latitude/Longitude		
				Start	End	
Item	Animal Control			36.820558 °	36.820000 °	
				-120.300616 °	-120.300831 °	
DWR ID	DWR_NA0010_17_s_2014_3					
Comment Code						
A3 : No rodents visible, but rodent burrows visible; need to backfill and compact or grout burrows.						
Inspector Comment						
Noted several rodent holes with this reach.

Looking at several rodent holes on landward slope. Spring 2015

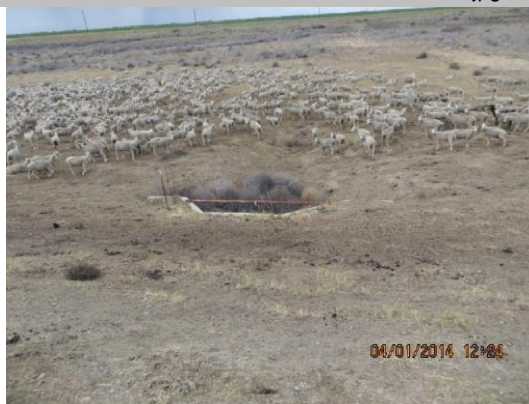
Photo 1 of 3 : UCIP_SP_2017_39533_59727.jpg

LM Start	13.29	Rating **	M	Issue No.	17
LM End	13.29	Issue Type +	Ma	Location *	LS
Category	Supplemental			GPS Latitude/Longitude	
				Start	End
Item	DWR UCIP LMA Responsibility			36.807509 °	36.807509 °
				-120.306231 °	-120.306231 °
DWR ID					
Comment Code					
Inspector Comment					
FS_ID:39533 DS_ID:19918 EP_NO: N/A Repair Type: Non-Urgent Crossing Status: Found UCIP Comments: Some vegetation buildup at inlet--recommend clearing. FIELD_STRUCT_DESC: 48x60-inch R.C.B.C. through the levee, 15.3 feet below the crown. Concrete "U" headwall on the waterward end. Flap gate on the waterward end. Concrete headwall on the landward end. (USACE-1967). This entry matches the Drainage or Irrigation Structure referenced in O&M manual (HLM 13.30). FS Date: 4/1/2014

Concrete headwall on WS toe.

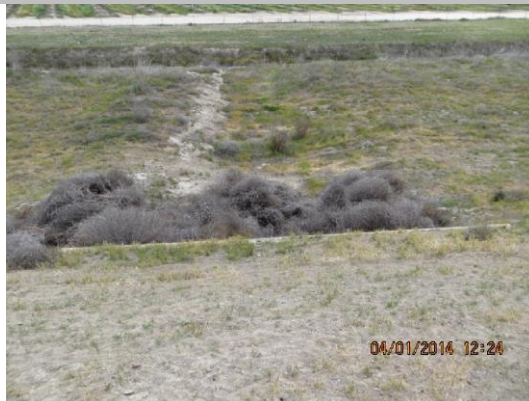
Photo 2 of 3 : UCIP_SP_2017_39533_59726.jpg

LM Start	13.29	Rating **	M	Issue No.	17 (cont)
LM End	13.29	Issue Type +	Ma	Location *	LS
Category	Supplemental			GPS Latitude/Longitude	
				Start	End
Item	DWR UCIP LMA Responsibility			36.807509 °	36.807509 °
				-120.306231 °	-120.306231 °
DWR ID					
Comment Code					
Inspector Comment					
FS_ID:39533 DS_ID:19918 EP_NO: N/A Repair Type: Non-Urgent Crossing Status: Found UCIP Comments: Some vegetation buildup at inlet--recommend clearing. FIELD_STRUCT_DESC: 48x60-inch R.C.B.C. through the levee, 15.3 feet below the crown. Concrete "U" headwall on the waterward end. Flap gate on the waterward end. Concrete headwall on the landward end. (USACE-1967). This entry matches the Drainage or Irrigation Structure referenced in O&M manual (HLM 13.30). FS Date: 4/1/2014

Concrete headwall on LS toe.

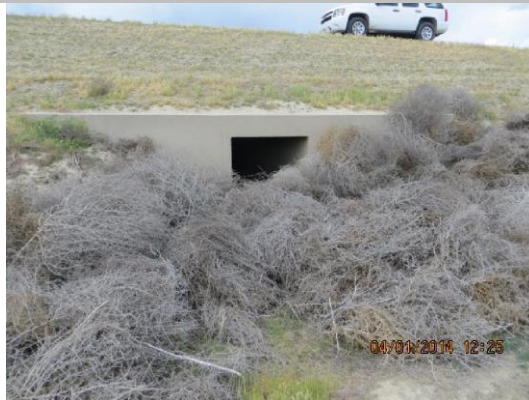
Photo 3 of 3 : UCIP_SP_2017_39533_59725.jpg

Concrete headwall on LS toe. Some vegetation buildup.

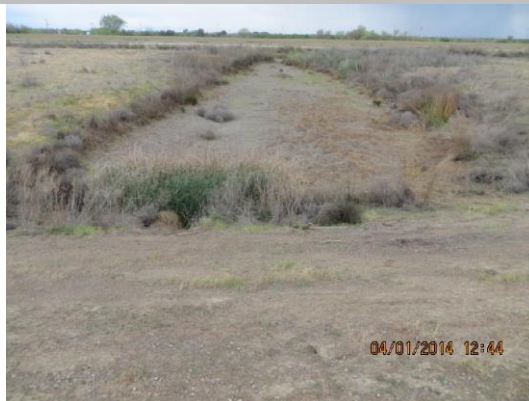
Photo 1 of 3 : UCIP_SP_2017_39535_59745.jpg

LM Start	14.69	Rating **	M	Issue No.	20
LM End	14.69	Issue Type +	Ma	Location *	LS
Category	Supplemental			GPS Latitude/Longitude	
				Start	End
Item	DWR UCIP LMA Responsibility			36.789066 °	36.789066 °
				-120.300644 °	-120.300644 °
DWR ID					
Comment Code					
Inspector Comment					
FS_ID:39535 DS_ID:19920 EP_NO: N/A Repair Type: Non-Urgent Crossing Status: Found UCIP Comments: Heavy vegetation buildup at LS toe--recommend clearing. FIELD_STRUCT_DESC: 30-inch square R.C.B.C. through the levee, 14.0 feet below the crown. Concrete "U" headwall on the waterward end. Flap gate on the waterward end. Concrete headwall on landward end. (USACE-1967). This entry matches the Drainage or Irrigation Structure referenced in O&M manual (HLM 14.69). FS Date: 4/1/2014

Concrete headwall at WS toe.

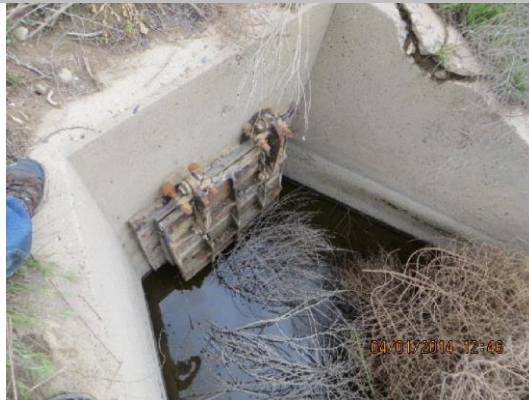
Photo 2 of 3 : UCIP_SP_2017_39535_59747.jpg

Flapgate on Concrete headwall at WS toe.

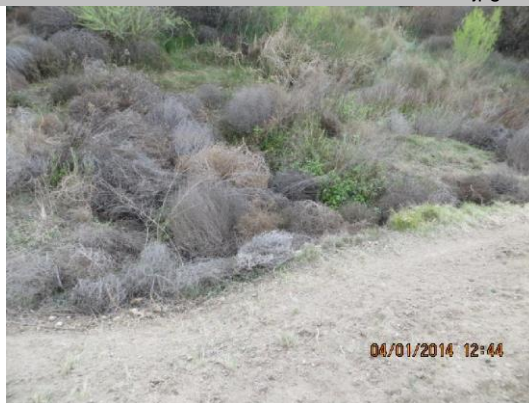
Photo 3 of 3 : UCIP_SP_2017_39535_59746.jpg

LM Start	14.69	Rating **	M	Issue No.	20 (cont)	
LM End	14.69	Issue Type +	Ma	Location *	LS	
Category	Supplemental			GPS Latitude/Longitude		
				Start		End
Item	DWR UCIP LMA Responsibility			36.789066 °		36.789066 °
				-120.300644 °		-120.300644 °
DWR ID						
Comment Code						
Inspector Comment						
FS_ID:39535 DS_ID:19920 EP_NO: N/A Repair Type: Non-Urgent Crossing Status: Found UCIP Comments: Heavy vegetation buildup at LS toe--recommend clearing. FIELD_STRUCT_DESC: 30-inch square R.C.B.C. through the levee, 14.0 feet below the crown. Concrete "U" headwall on the waterward end. Flap gate on the waterward end. Concrete headwall on landward end. (USACE-1967). This entry matches the Drainage or Irrigation Structure referenced in O&M manual (HLM 14.69). FS Date: 4/1/2014

Concrete headwall at channel on LS toe. Heavy vegetation buildup.

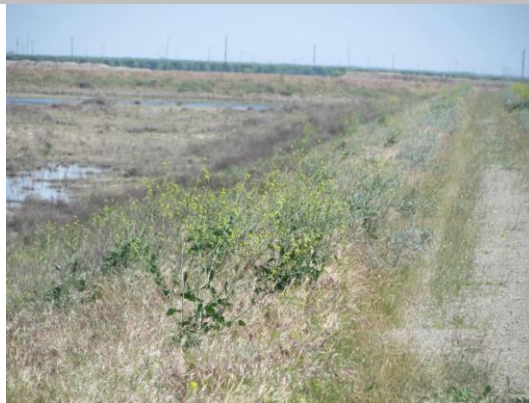
Photo 1 of 1 : SP_2017_NA0010_137_6_20170425_00018.jpg

LM Start	0.00	Rating **	M	Issue No.	6
LM End	15.32	Issue Type +	Ma	Location *	WS
Category	Earthen Levee			GPS Latitude/Longitude	
				Start	End
Item	Vegetation			36.974133 °	36.773888 °
				-120.363257 °	-120.285360 °
DWR ID	DWR_NA0010_18_s_2017_6				
Comment Code					
V1 : Control annual grass and weeds on the levee slopes and easements.					
Inspector Comment

Looking at typical view of waterward slope.

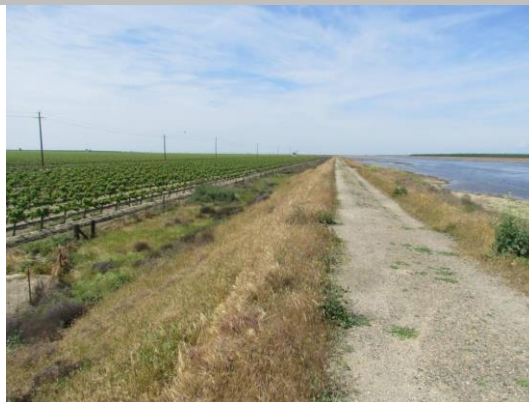
Photo 1 of 1 : SP_2017_NA0010_137_10_20170425_00019.jpg

LM Start	0.00	Rating **	M	Issue No.	10
LM End	13.24	Issue Type +	Ma	Location *	LS
Category	Earthen Levee			GPS Latitude/Longitude	
				Start	End
Item	Vegetation			36.974113 °	36.796253 °
				-120.363258 °	-120.308384 °
DWR ID	DWR_NA0010_18_f_2016_10				
Comment Code					
V1 : Control annual grass and weeds on the levee slopes and easements.					
Inspector Comment					
Control veg.on levee shoulder and slope.

Looking at typical view of landward slope.

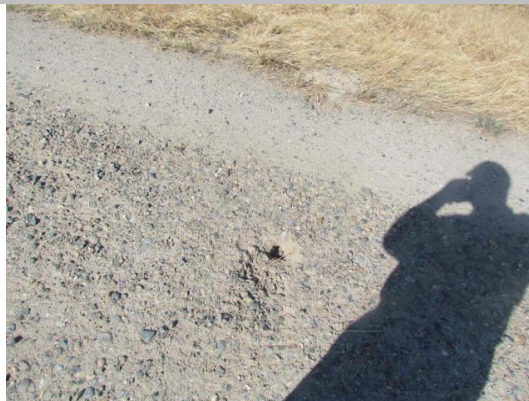
Photo 1 of 1 : SP_2017_NA0010_137_7_20170417_00002.jpg

LM Start	1.44	Rating **	M	Issue No.	7
LM End	1.44	Issue Type +	Ma	Location *	LS
Category	Earthen Levee			GPS Latitude/Longitude	
				Start	End
Item	Animal Control			36.956163 °	36.956163 °
				-120.353672 °	-120.353672 °
DWR ID	DWR_NA0010_18_s_2014_7				
Comment Code					
A3 : No rodents visible, but rodent burrows visible; need to backfill and compact or grout burrows.					
Inspector Comment					
Several noted on landward slope and on levee crown.

Looking at typical view of rodent holes within this section on landward slope.

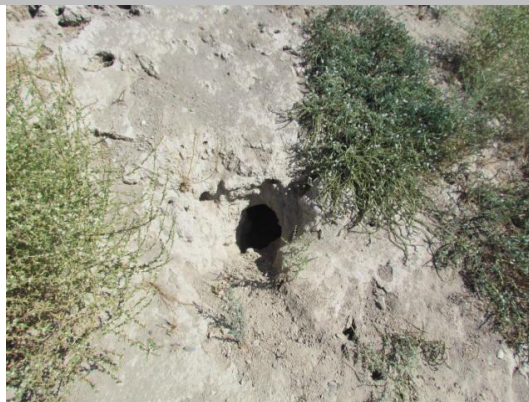
Photo 1 of 2 : SP_2017_NA0010_137_8_20170417_00003.jpg

LM Start	2.25	Rating **	U	Issue No.	8	
LM End	2.25	Issue Type +	Ma	Location *	LS	
Category	Earthen Levee			GPS Latitude/Longitude		
				Start		End
Item	Animal Control			36.945563 °		36.945563 °
				-120.347121 °		-120.347121 °
DWR ID	DWR_NA0010_18_f_2015_8					
Comment Code						
A3 : No rodents visible, but rodent burrows visible; need to backfill and compact or grout burrows.						
Inspector Comment						
One large rodent hole and other rodent holes within this area.

Looking at large rodent hole on landward slope.

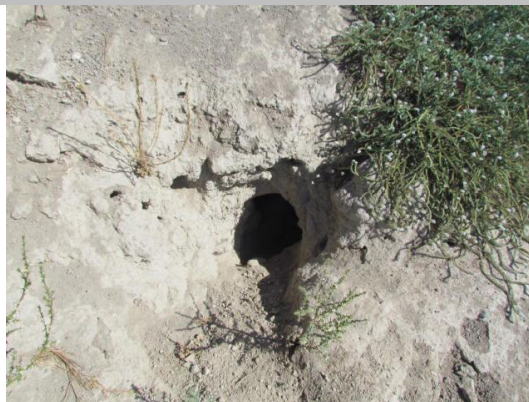
Photo 2 of 2 : SP_2017_NA0010_137_8_20170417_00004.jpg

Looking at close-up view of large rodent hole on landward slope.

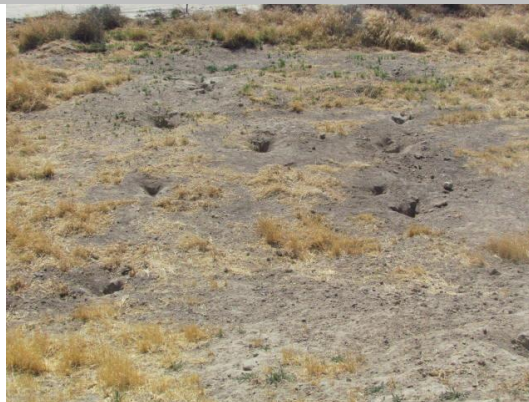
Photo 1 of 1 : SP_2017_NA0010_137_1_20170417_00001.jpg

LM Start	5.89	Rating **	M	Issue No.	1
LM End	5.89	Issue Type +	Ma	Location *	LS
Category	Earthen Levee			GPS Latitude/Longitude	
				Start	End
Item	Animal Control			36.895175 °	36.895175 °
				-120.327632 °	-120.327632 °
DWR ID	DWR_NA0010_18_s_2015_1				
Comment Code					
A3 : No rodents visible, but rodent burrows visible; need to backfill and compact or grout burrows.					
Inspector Comment					
Several large rodent holes noted on landward slope and berm within this section.

Looking at several rodent holes on landward slope.

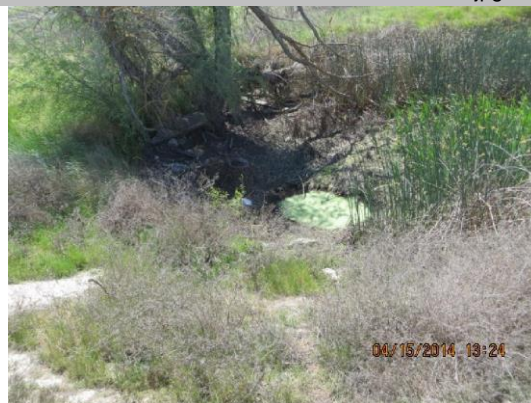
Photo 2 of 3 : UCIP_SP_2017_49959_61061.jpg

FS_ID:49959
DS_ID:19933
EP_NO: N/A
Repair Type: Non-Urgent
Crossing Status: Found
UCIP Comments: 07/19/2016 Gate inside riser appears operable--riser lid damage. Crossing is not visible on LS due to dense vegetation. Recommend clearing dense vegetation along WS and LS slope and repairing riser cover. (DWR UCIP - omagana)04/15/2014 No actuator wheel on slide gate at WS shoulder. (DWR UCIP - omagana)
FIELD_STRUCT_DESC: 24-inch corrugated metal drainage pipe through the levee, 14.8 feet below the crown. Slide gate inside 36-inch corrugated metal pipe (CMP) riser located on the the waterside (WS) slope. Concrete "U" headwalls on both WS and landside (LS) ends.
[Additional Reference(s): DWR Levee Log, 2002. USACE San Joaquin O&M Manuals: Unit No. 601, 1967, (HLM 0.10), Unit No. 601 Part I, 1967 (Amended in 1978), Unit No. 601 Part II, 1969, and Unit No. 601 Part III, 1969].
FS Date: 7/19/2016

Concrete headwall at toe of LS slope.

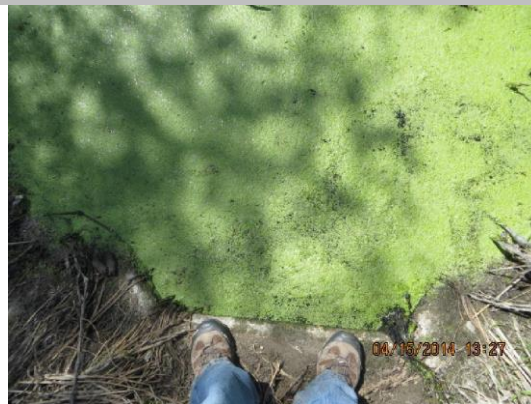
Photo 3 of 3 : UCIP_SP_2017_49959_61059.jpg

Concrete headwall at LS toe.

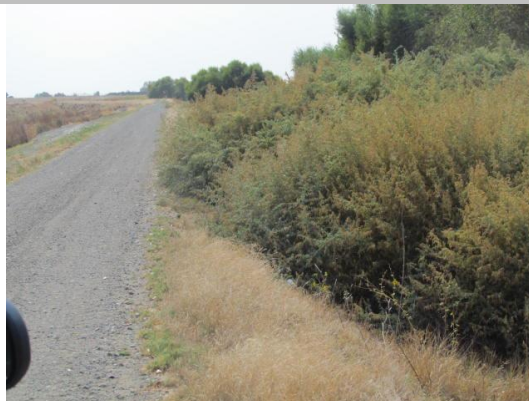
Photo 1 of 2 : SP_2017_NA0010_138_21_20170417_00012.jpg

LM Start	0.53	Rating **	U	Issue No.	21
LM End	0.85	Issue Type +	Ma	Location *	LS
Category	Earthen Levee			GPS Latitude/Longitude	
				Start	End
Item	Vegetation			37.213006 °	37.217593 °
				-120.698019 °	-120.697400 °
DWR ID	DWR_NA0010_22A_f_2014_21				
Comment Code					
V2 : Remove the wild growth other than native grasses from the levee slopes.					
Inspector Comment					
Dense vegetation on landward slope.

Looking at dense vegetation on landward slope. Fall 2015

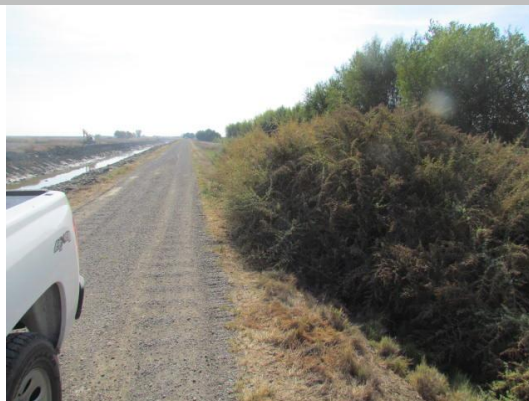
Photo 2 of 2 : SP_2017_NA0010_138_21_20170417_00013.jpg

Looking south at dense vegetation on landward slope. Spring 2015

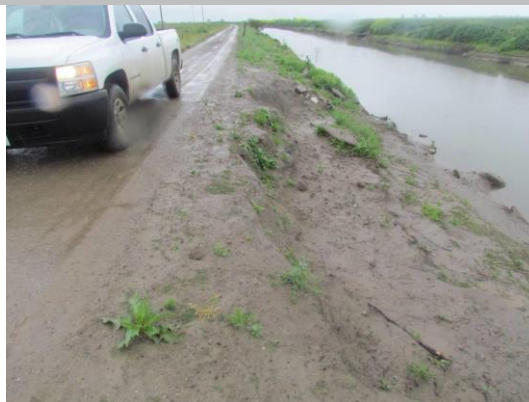
Photo 1 of 1 : SP_2017_NA0010_138_7_20170425_00028.jpg

LM Start	2.65	Rating **	U	Issue No.	7
LM End	2.65	Issue Type +	Ma	Location *	WS
Category	Earthen Levee			GPS Latitude/Longitude	
				Start	End
Item	Erosion / Bank Caving			37.242595 °	37.242595 °
				-120.706470 °	-120.706470 °
DWR ID	DWR_NA0010_22A_s_2017_7				
Comment Code					
E2 : Schedule repair of erosion site prior to the next inspection.					
Inspector Comment					
Erosion cutting into waterward shoulder.

Looking downstream at erosion on waterward shoulder and slope.

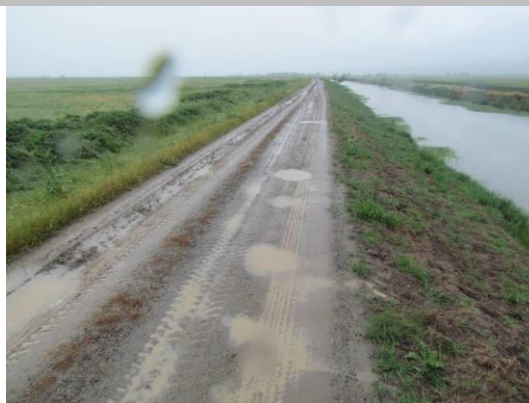
Photo 1 of 1 : SP_2017_NA0010_138_10_20170425_00029.jpg

LM Start	2.65	Rating **	U	Issue No.	10
LM End	5.09	Issue Type +	Ma	Location *	CR
Category	Earthen Levee			GPS Latitude/Longitude	
				Start	End
Item	Crown Surface / Depressions / Rutting			37.242595 °	37.267962 °
				-120.706470 °	-120.736909 °
DWR ID	DWR_NA0010_22A_s_2012_10				
Comment Code					
C2 : Repair depressions or ruts in the crown or slope.					
Inspector Comment					
Several pot holes and depression along levee crown.

Looking downstream at rutting and potholes on levee crown.

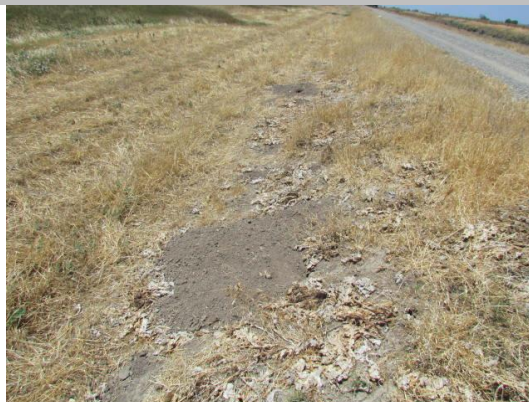
Photo 1 of 1 : SP_2017_NA0010_138_15_20170417_00011.jpg

LM Start	2.86	Rating **	M	Issue No.	15
LM End	3.05	Issue Type +	Ma	Location *	LS
Category	Earthen Levee			GPS Latitude/Longitude	
				Start	End
Item	Animal Control			37.245431 °	37.247343 °
				-120.707990 °	-120.710362 °
DWR ID	DWR_NA0010_22A_s_2014_15				
Comment Code					
A3 : No rodents visible, but rodent burrows visible; need to backfill and compact or grout burrows.					
Inspector Comment					
Noted several rodent holes on landward slope and toe.

Looking at several rodent holes on landward slope.

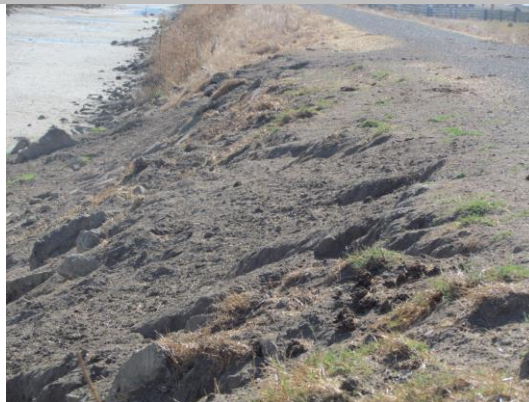
Photo 1 of 1 : SP_2017_NA0010_138_9_20170417_00007.jpg

LM Start	3.64	Rating **	U	Issue No.	9
LM End	3.69	Issue Type +	Ma	Location *	WS
Category	Earthen Levee			GPS Latitude/Longitude	
				Start	End
Item	Erosion / Bank Caving			37.253362 °	37.253862 °
				-120.717873 °	-120.718507 °
DWR ID	DWR_NA0010_22A_f_2016_9				
Comment Code					
E1 : Note and monitor erosion site.					
Inspector Comment					
Erosion or Levee damage caused by animal traffic.

Looking downstream at animal erosion on waterward slope.

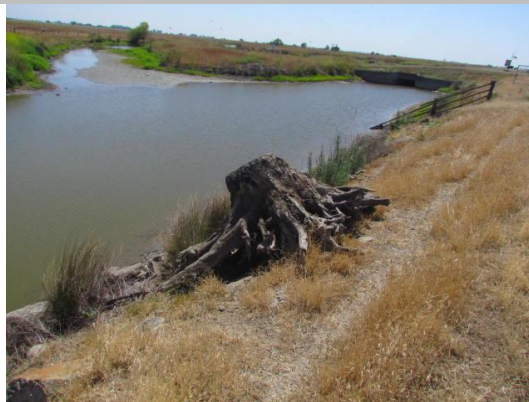
Photo 1 of 1 : SP_2017_NA0010_138_259_20170417_00015.jpg

LM Start	3.80	Rating **	M	Issue No.	259
LM End	3.80	Issue Type +	Ma	Location *	WS
Category	Earthen Levee			GPS Latitude/Longitude	
				Start	End
Item	Encroachments			37.255067 °	37.255067 °
				-120.719910 °	-120.719910 °
DWR ID	DWR_NA0010_22A_s_2015_259				
Comment Code					
TR : Tree or limb					
Inspector Comment					
Dead tree stump on waterward slope.

Looking east at dead stump on waterward slope.

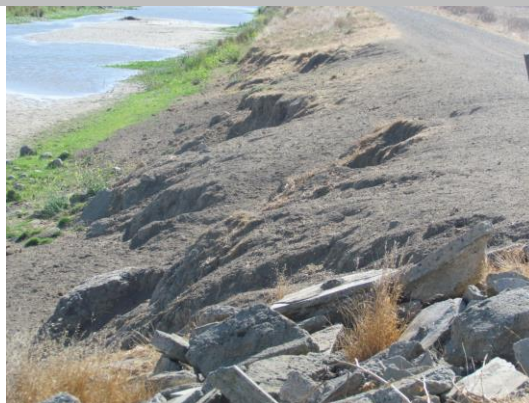
Photo 1 of 2 : SP_2017_NA0010_138_8_20170417_00005.jpg

LM Start	4.87	Rating **	U	Issue No.	8
LM End	4.87	Issue Type +	Ma	Location *	WS
Category	Earthen Levee			GPS Latitude/Longitude	
				Start	End
Item	Slope Stability			37.265813 °	37.265813 °
				-120.733748 °	-120.733748 °
DWR ID	DWR_NA0010_22A_f_2016_8				
Comment Code					
S1 : Repair slope instability.					
Inspector Comment					
Levee damage caused by animal traffic.

Looking downstream at animal erosion on waterward slope.

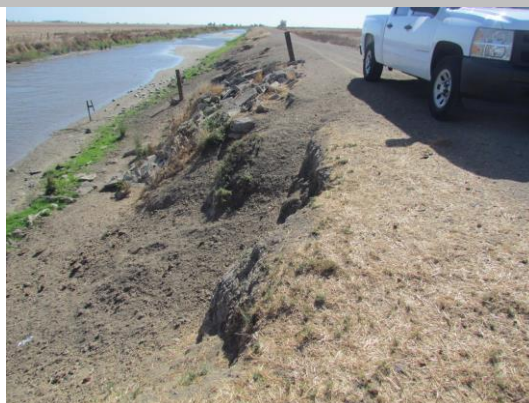
Photo 2 of 2 : SP_2017_NA0010_138_8_20170417_00006.jpg

Looking downstream at animal erosion on waterward slope.

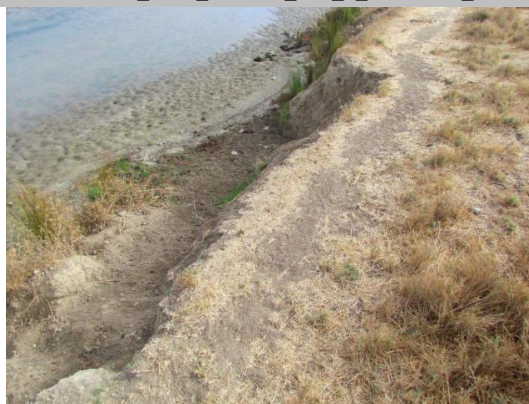
Photo 1 of 2 : SP_2017_NA0010_138_4_20170417_00001.jpg

LM Start	5.05	Rating **	M	Issue No.	4
LM End	5.05	Issue Type +	Ma	Location *	WS
Category	Earthen Levee			GPS Latitude/Longitude	
				Start	End
Item	Erosion / Bank Caving			37.267516 °	37.267516 °
				-120.736401 °	-120.736401 °
DWR ID	DWR_NA0010_22A_f_2013_4				
Comment Code					
E2 : Schedule repair of erosion site prior to the next inspection.					
Inspector Comment					
Erosion caused by animal traffic.

Looking southeast at livestock erosion on waterward toe.

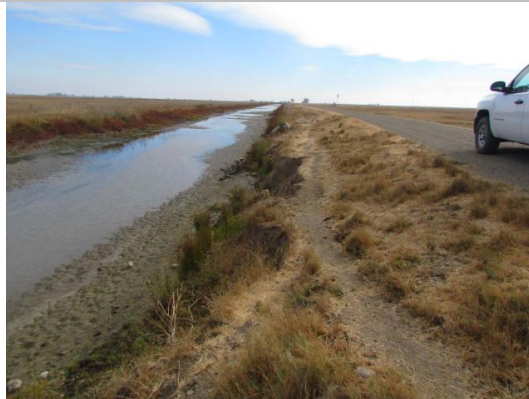
Photo 2 of 2 : SP_2017_NA0010_138_4_20170417_00002.jpg

LM Start	5.05	Rating **	M	Issue No.	4 (cont)	
LM End	5.05	Issue Type +	Ma	Location *	WS	
Category	Earthen Levee			GPS Latitude/Longitude		
				Start		End
Item	Erosion / Bank Caving			37.267516 °		37.267516 °
				-120.736401 °		-120.736401 °
DWR ID	DWR_NA0010_22A_f_2013_4					
Comment Code						
E2 : Schedule repair of erosion site prior to the next inspection.						
Inspector Comment						
Erosion caused by animal traffic.

Looking southeast at livestock erosion on waterward toe.

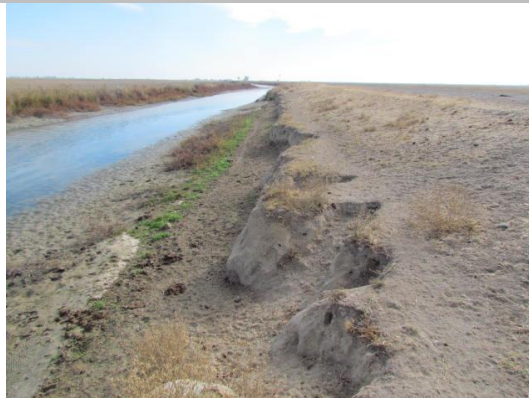
Photo 1 of 2 : SP_2017_NA0010_138_6_20170417_00003.jpg

LM Start	5.14	Rating **	M	Issue No.	6
LM End	5.20	Issue Type +	Ma	Location *	WS
Category	Earthen Levee			GPS Latitude/Longitude	
				Start	End
Item	Animal Control			37.268492 °	37.269133 °
				-120.737493 °	-120.738208 °
DWR ID	DWR_NA0010_22A_s_2012_6				
Comment Code					
A2 : Repair the levee slope damaged by livestock and prevent large animal access.					
Inspector Comment					
Slope damage caused by livestock on waterside toe.

Looking southeast at livestock erosion on waterward toe.

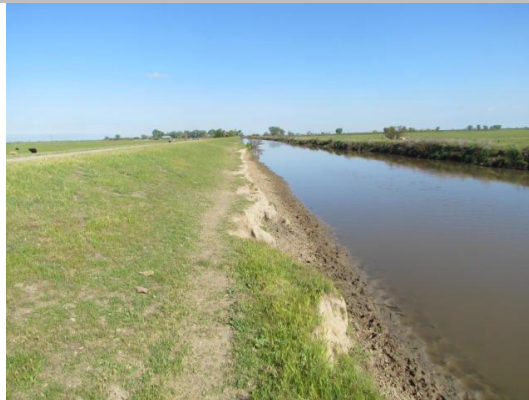
Photo 2 of 2 : SP_2017_NA0010_138_6_20170417_00004.jpg

Looking northwest at livestock erosion along waterside slope and toe.

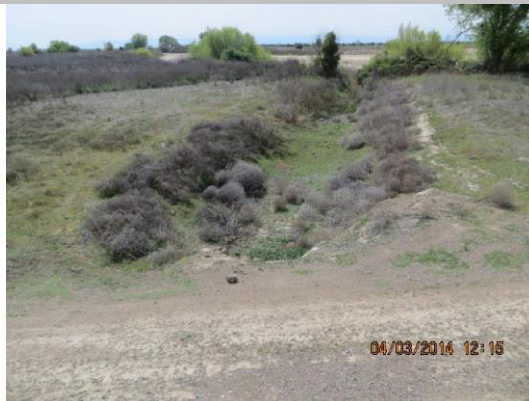
Photo 1 of 3 : UCIP_SP_2017_39537_59860.jpg

FS_ID:39537
DS_ID:19945
EP_NO: N/A
Repair Type: Non-Urgent
Crossing Status: Found
UCIP Comments: Excessive vegetation at inlet--recommend clearing.
FIELD_STRUCT_DESC: 30-inch square R.C.B.C. through the levee 13.0 feet below the crown. Concrete "U" headwall on the waterward end. Flap gate on the waterward end. Concrete headwall on the landward end. (USACE-1967). This entry matches the Drainage or Irrigation Structure referenced in O&M manual (HLM 0.21). Cleaned and rehabilitated under Permit No. 13085 (1981).
FS Date: 4/3/2014

Concrete headwall on WS toe at channel.

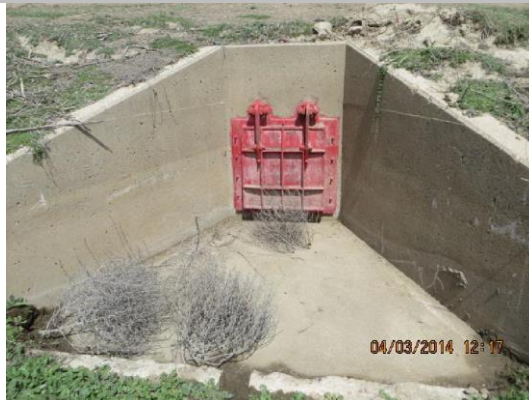
Photo 2 of 3 : UCIP_SP_2017_39537_59859.jpg

Flapgate on Concrete headwall at WS toe.

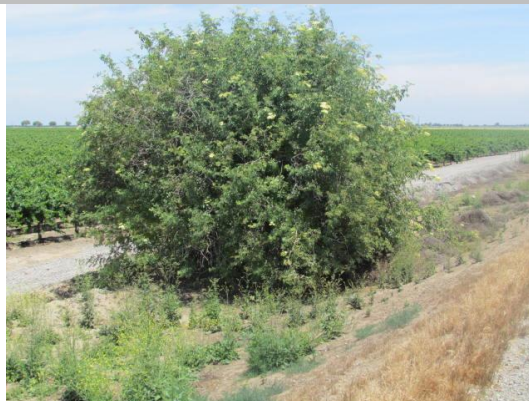
Photo 1 of 1 : SP_2017_NA0010_139_6_20170417_00007.jpg

LM Start	1.21	Rating **	M	Issue No.	6
LM End	1.21	Issue Type +	Ma	Location *	LS
Category	Earthen Levee			GPS Latitude/Longitude	
				Start	End
Item	Vegetation			36.772973 °	36.772973 °
				-120.264768 °	-120.264768 °
DWR ID	DWR_NA0010_23_s_2013_6				
Comment Code					
V4 : Elderberries are blocking visibility and flood fight capability.					
Inspector Comment					
Control growth of elderberry on landward toe.

Looking at elderberry on landward toe.

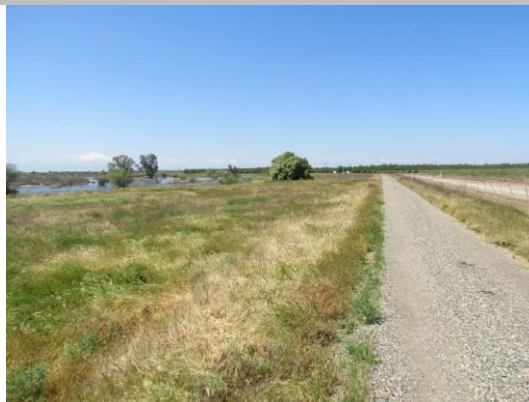
Photo 1 of 1 : SP_2017_NA0010_139_21_20170425_00057.jpg

LM Start	1.64	Rating **	M	Issue No.	21
LM End	9.50	Issue Type +	Ma	Location *	WS
Category	Earthen Levee			GPS Latitude/Longitude	
				Start	End
Item	Vegetation			36.771398 °	36.804327 °
				-120.257659 °	-120.169140 °
DWR ID	DWR_NA0010_23_f_2016_21				
Comment Code					
V1 : Control annual grass and weeds on the levee slopes and easements.					
Inspector Comment					
Control vegetation on levee slope.

Looking at typical view of waterward slope.

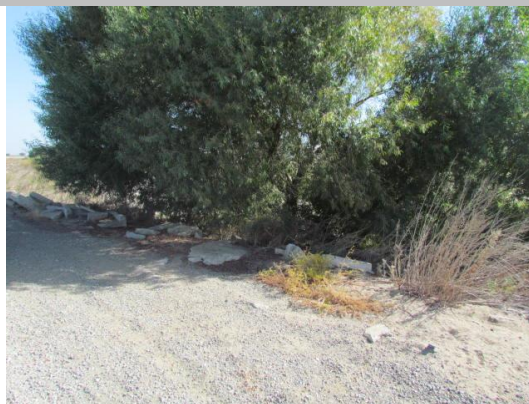
Photo 1 of 1 : SP_2017_NA0010_139_1_20170417_00001.jpg

LM Start	1.91	Rating **	U	Issue No.	1
LM End	1.91	Issue Type +	Ma	Location *	WS
Category	Earthen Levee			GPS Latitude/Longitude	
				Start	End
Item	Trim / Thin Trees			36.772943 °	36.772943 °
				-120.253511 °	-120.253511 °
DWR ID	DWR_NA0010_23_s_2015_1				
Comment Code					
T1 : Trim trees to at least five feet above ground level.					
Inspector Comment					
Untrimmed tree on waterward slope

Looking at untrimmed tree on waterward slope.

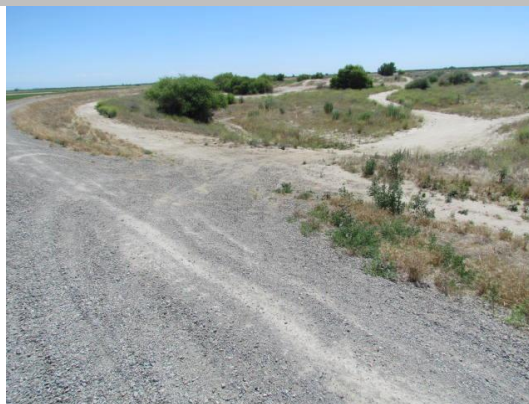
Photo 1 of 1 : SP_2017_NA0010_139_16_20170417_00017.jpg

LM Start	2.12	Rating **	M	Issue No.	16
LM End	2.42	Issue Type +	Ma	Location *	WS
Category	Earthen Levee			GPS Latitude/Longitude	
				Start	End
Item	Slope Stability			36.775507 °	36.774423 °
				-120.251672 °	-120.246993 °
DWR ID	DWR_NA0010_23_s_2013_16				
Comment Code					
S3 : Repair the levee slope damaged by vehicle traffic and prevent access where possible.					
Inspector Comment					
Several damaged sites within this reach. Damage caused by vehicle traffic. At. LM. 2.12, 2.21, 2.37, & 2.41

Looking west at one of several slope damaged cause by vehicle traffice.

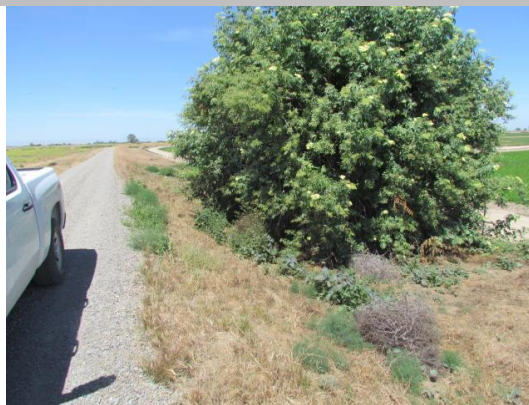
Photo 1 of 3 : SP_2017_NA0010_139_15_20170417_00014.jpg

Looking west at elderberry at landward toe. (Spring 2016)

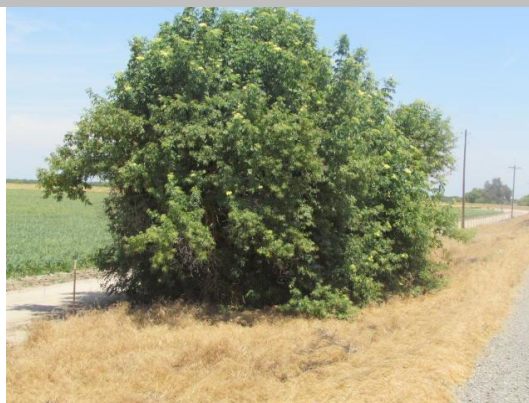
Photo 2 of 3 : SP_2017_NA0010_139_15_20170417_00015.jpg

Looking east at elderberry at landward toe. (Spring 2015)

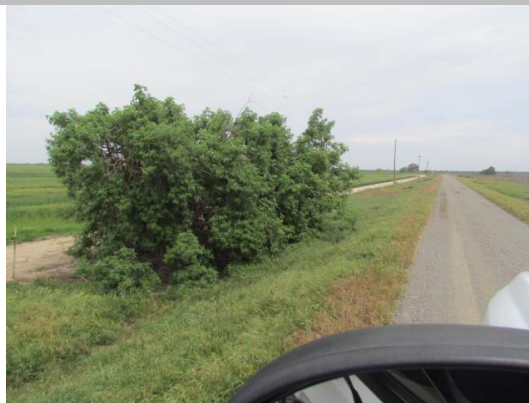
Photo 3 of 3 : SP_2017_NA0010_139_15_20170417_00016.jpg

Looking east at elderberry on landside toe and berm. (Fall 2014)

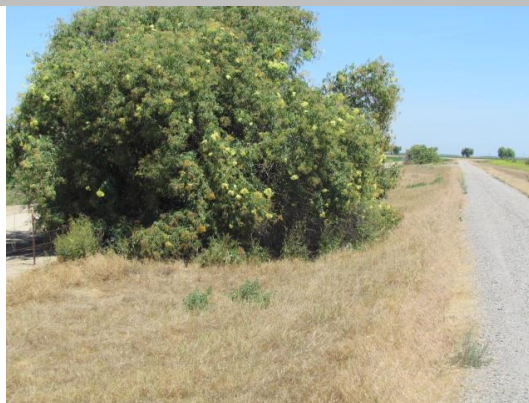
Photo 1 of 4 : SP_2017_NA0010_139_3_20170417_00002.jpg

Looking North at elderberry on landward toe and berm. (Spring 2016)

LM Start	3.30	Rating **	U	Issue No.	3 (cont)	
LM End	3.30	Issue Type +	Ma	Location *	LS	
Category	Earthen Levee			GPS Latitude/Longitude		
				Start		End
Item	Vegetation			36.774403 °		36.774403 °
				-120.234705 °		-120.234705 °
DWR ID	DWR_NA0010_23_s_2012_3					
Comment Code						
V4 : Elderberries are blocking visibility and flood fight capability.						
Inspector Comment						
Control growth of elderberry on landward toe.

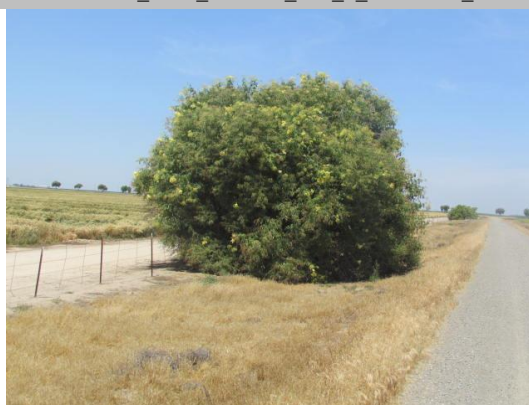
Photo 2 of 4 : SP_2017_NA0010_139_3_20170417_00003.jpg

Looking north at elderberry on landward toe and berm. (Spring 2015)

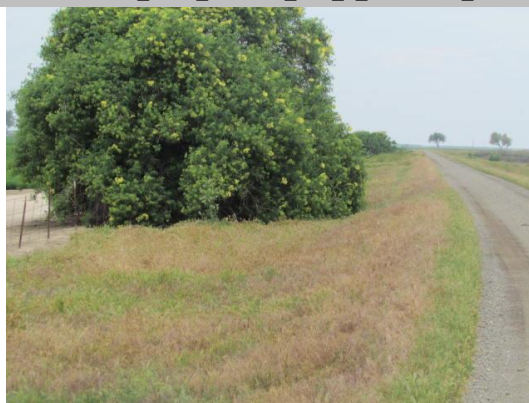
Photo 3 of 4 : SP_2017_NA0010_139_3_20170417_00004.jpg

Looking north at elderberry on landside toe and berm. (Fall 2014)

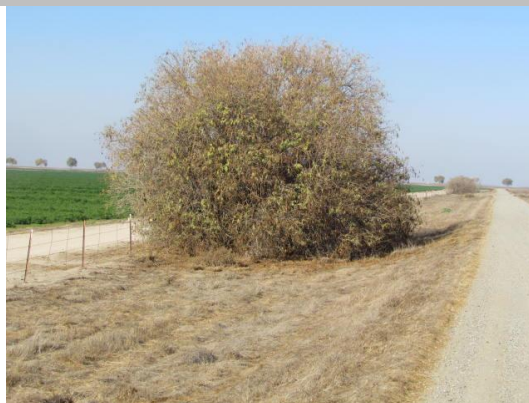
Photo 4 of 4 : SP_2017_NA0010_139_3_20170417_00005.jpg

Looking north at elderberry bush on landward toe. (Spring 2013)

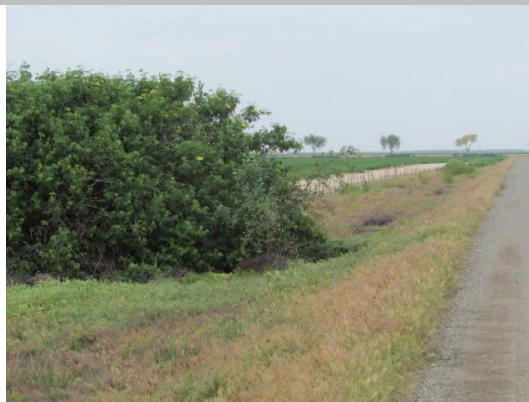
Photo 1 of 1 : SP_2017_NA0010_139_9_20170417_00008.jpg

LM Start	3.45	Rating **	M	Issue No.	9
LM End	3.45	Issue Type +	Ma	Location *	LS
Category	Earthen Levee			GPS Latitude/Longitude	
				Start	End
Item	Vegetation			36.776537 °	36.776537 °
				-120.234573 °	-120.234573 °
DWR ID	DWR_NA0010_23_s_2012_9				
Comment Code					
V4 : Elderberries are blocking visibility and flood fight capability.					
Inspector Comment					
Control growth of elderberry on landward toe and berm.

Looking north at elderberry on landside toe and berm.

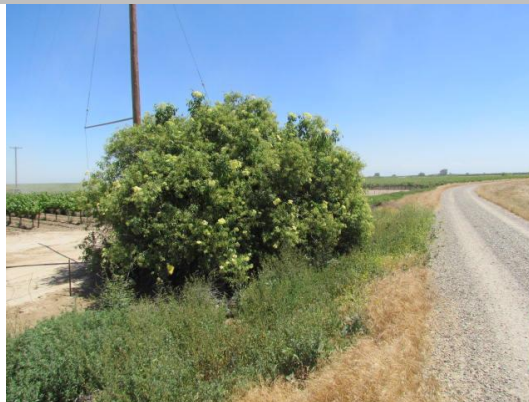
Photo 1 of 3 : SP_2017_NA0010_139_10_20170417_00009.jpg

LM Start	4.13	Rating **	U	Issue No.	10
LM End	4.13	Issue Type +	Ma	Location *	LS
Category	Earthen Levee			GPS Latitude/Longitude	
				Start	End
Item	Vegetation			36.784212 °	36.784212 °
				-120.228815 °	-120.228815 °
DWR ID	DWR_NA0010_23_s_2012_10				
Comment Code					
V4 : Elderberries are blocking visibility and flood fight capability.					
Inspector Comment					
Control growth of elderberry on landward toe.

Looking east at elderberry bush on landward toe. (Spring 2016)
