**Flood Control Project Maintenance
Levee Inspections**

Maintenance Issue Types Only, Levee Inspection Report By Mile - Spring 2017

Lower San Joaquin Levee District

Waterway	Bank	Unit Miles	Inspection Start/End	Inspector
Unit No. 01 San Joaquin River	Right	22.52	04/17/2017 04/20/2017	Richard Willoughby

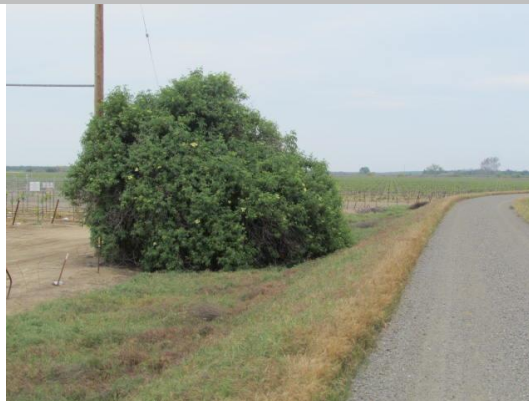
Photo 2 of 3 : SP_2017_NA0010_139_10_20170417_00010.jpg

LM Start	4.13	Rating **	U	Issue No.	10 (cont)	
LM End	4.13	Issue Type +	Ma	Location *	LS	
Category	Earthen Levee			GPS Latitude/Longitude		
				Start	End	
Item	Vegetation			36.784212°	36.784212°	
				-120.228815°	-120.228815°	
DWR ID	DWR_NA0010_23_s_2012_10					
Comment Code						
V4 : Elderberries are blocking visibility and flood fight capability.						
Inspector Comment						
Control growth of elderberry on landward toe.

Looking east at elderberry on landside toe and berm. (Spring 2015)

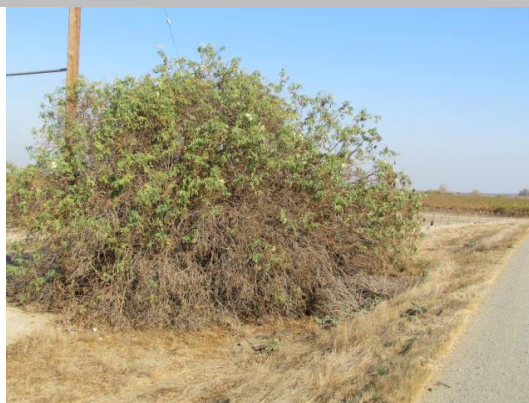
Photo 3 of 3 : SP_2017_NA0010_139_10_20170417_00011.jpg

Looking east at elderberry bush on landward toe. (Fall 2013)

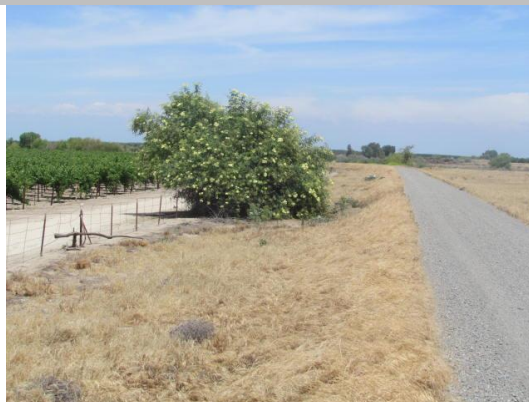
Photo 1 of 2 : SP_2017_NA0010_139_11_20170417_00012.jpg

LM Start	4.45	Rating **	M	Issue No.	11
LM End	4.45	Issue Type +	Ma	Location *	LS
Category	Earthen Levee			GPS Latitude/Longitude	
				Start	End
Item	Vegetation			36.784523 °	36.784523 °
				-120.223292 °	-120.223292 °
DWR ID	DWR_NA0010_23_s_2012_11				
Comment Code					
V4 : Elderberries are blocking visibility and flood fight capability.					
Inspector Comment					
Control growth of elderberry on landward toe and berm.

Looking northeast at elderberry on landward toe and berm. (Spring 2015)

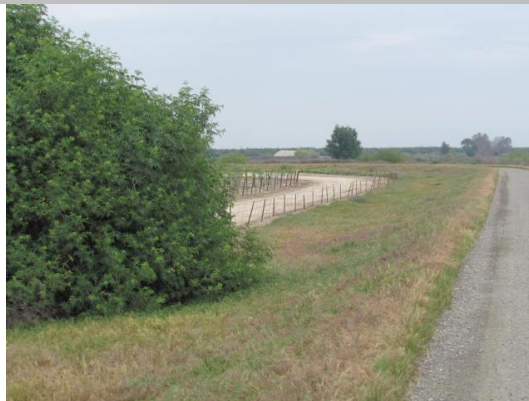
Photo 2 of 2 : SP_2017_NA0010_139_11_20170417_00013.jpg

LM Start	4.45	Rating **	M	Issue No.	11 (cont)	
LM End	4.45	Issue Type +	Ma	Location *	LS	
Category	Earthen Levee			GPS Latitude/Longitude		
				Start	End	
Item	Vegetation			36.784523 °	36.784523 °	
				-120.223292 °	-120.223292 °	
DWR ID	DWR_NA0010_23_s_2012_11					
Comment Code						
V4 : Elderberries are blocking visibility and flood fight capability.						
Inspector Comment						
Control growth of elderberry on landward toe and berm.

Looking northeast at elderberry on landside toe and berm.

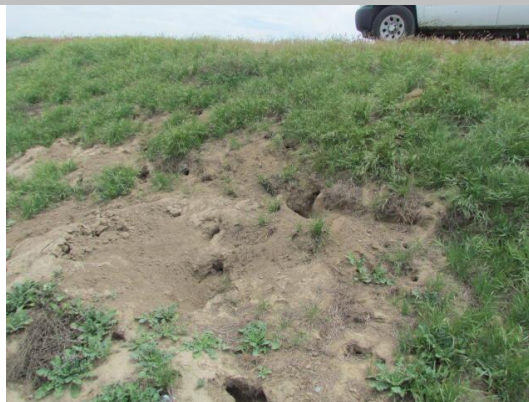
Photo 1 of 1 : SP_2017_NA0010_139_5_20170417_00006.jpg

LM Start	5.68	Rating **	U	Issue No.	5
LM End	5.68	Issue Type +	Ma	Location *	WS
Category	Earthen Levee			GPS Latitude/Longitude	
				Start	End
Item	Animal Control			36.791981 °	36.791981 °
				-120.206274 °	-120.206274 °
DWR ID	DWR_NA0010_23_s_2012_5				
Comment Code					
A1 : Exterminate rodents and backfill and compact or grout burrows.					
Inspector Comment					
Several large rodent holes in this area.

Looking at several rodent holes on landside slope.

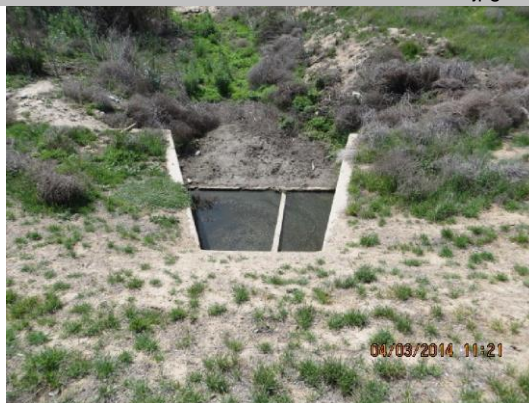
Photo 1 of 3 : UCIP_SP_2017_39542_59830.jpg

FS_ID:39542
DS_ID:19954
EP_NO: N/A
Repair Type: Non-Urgent
Crossing Status: Found
UCIP Comments: Dense vegetation limits the inspector's visibility to identify signs of pipe failure (leaks) along the landward slope. Recommend removing vegetation along pipe alignment to conduct proper inspection of structure.
FIELD_STRUCT_DESC: 36-inch square R.C.B.C through the levee 9.0 feet below the crown. Concrete "U" headwalls on both ends. Flap gate on the waterward end. Outlet channel cobble revetted 5.0 feet long. (USACE-1967). This entry matches the Drainage or Irrigation Structure referenced in O&M manual (HLM 5.71).
FS Date: 4/3/2014

Concrete headwall on WS toe.

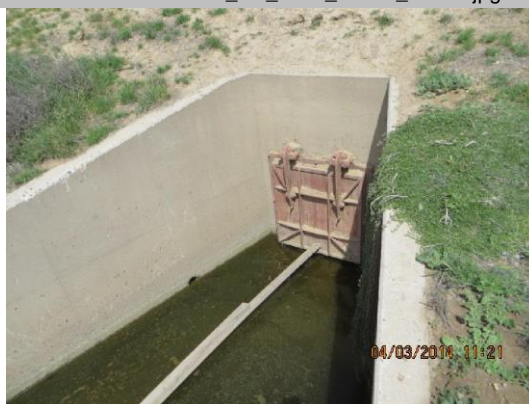
Photo 2 of 3 : UCIP_SP_2017_39542_59829.jpg

Flapgate on Concrete headwall on WS toe.

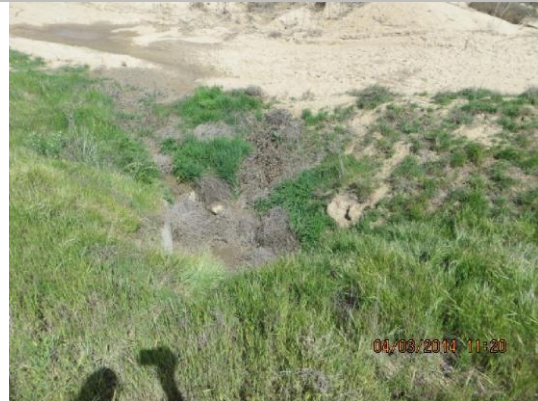
Photo 3 of 3 : UCIP_SP_2017_39542_59831.jpg

LM Start	5.68	Rating **	M	Issue No.	34 (cont)	
LM End	5.68	Issue Type +	Ma	Location *	WS	
Category	Supplemental			GPS Latitude/Longitude		
				Start	End	
Item	DWR UCIP LMA Responsibility			36.791936 °	36.791936 °	
				-120.206226 °	-120.206226 °	
DWR ID						
Comment Code						
Inspector Comment						
FS_ID:39542 DS_ID:19954 EP_NO: N/A Repair Type: Non-Urgent Crossing Status: Found UCIP Comments: Dense vegetation limits the inspector's visibility to proper inspection of structure. FIELD_STRUCT_DESC: 36-inch square R.C.B.C through the levee 9.0 feet below the crown. Concrete "U" headwalls on both ends. Flap gate on the waterward end. Outlet channel cobble revetted 5.0 feet long. (USACE-1967). This entry matches the Drainage or Irrigation Structure referenced in O&M manual (HLM 5.71). FS Date: 4/3/2014

Concrete headwall at LS toe.

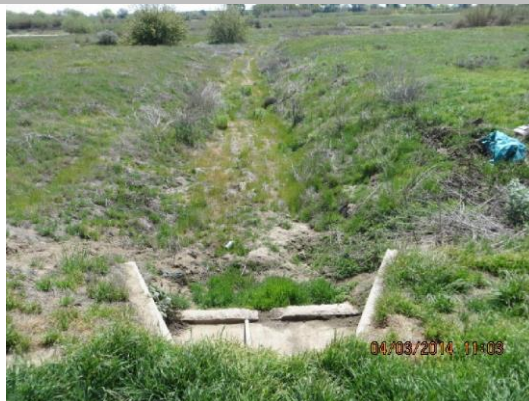
Photo 2 of 3 : UCIP_SP_2017_39544_59821.jpg

FS_ID:39544
DS_ID:19940
EP_NO: N/A
Repair Type: Non-Urgent
Crossing Status: Found
UCIP Comments: Some sediment buildup at inlet at LS toe. Also dense vegetation limits the inspector's visibility to identify signs of pipe failure (leaks) along the landward slope. Recommend removing vegetation along pipe alignment to conduct proper inspection of structure.
FIELD_STRUCT_DESC: 30-inch square R.C.B.C. through the levee, 5.2 feet below the crown. Concrete "U" headwall on the waterward end. Flap gate on the waterward end. Concrete headwalls on the landward end. (USACE-1967). This entry matches the Drainage or Irrigation Structure referenced in O&M manual (HLM 8.33).
FS Date: 4/3/2014

concrete headwall at drainage ditch on WS toe.

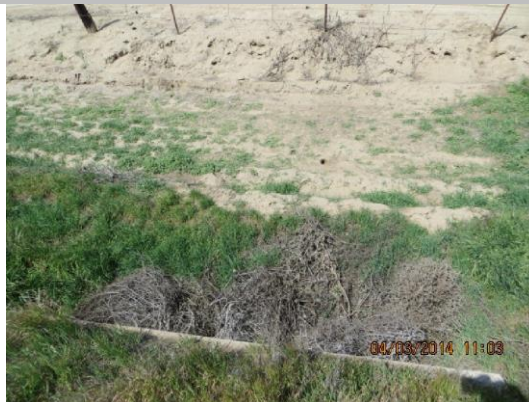
Photo 3 of 3 : UCIP_SP_2017_39544_59822.jpg

Concrete headwall on LS toe.

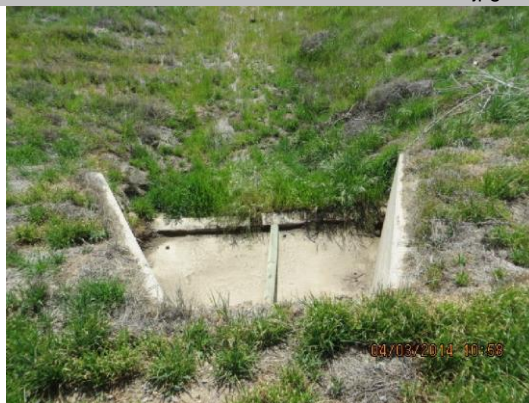
Photo 1 of 3 : UCIP_SP_2017_39545_59817.jpg

FS_ID:39545
DS_ID:19941
EP_NO: N/A
Repair Type: Non-Urgent
Crossing Status: Found
UCIP Comments: Dense vegetation limits the inspector's visibility to identify signs of pipe failure (leaks) along the landward slope. Recommend removing vegetation along pipe alignment to conduct proper inspection of structure.
FIELD_STRUCT_DESC: 30-inch square R.C.B.C. through the levee, 5.6 feet below the crown. Concrete "U" headwall on the waterward end. Flap gate on the waterward end. Concrete headwall on the landward end. (USACE-1967). This entry matches the Drainage or Irrigation Structure referenced in O&M manual (HLM 8.54).
FS Date: 4/3/2014

Concrete headwall on WS toe.

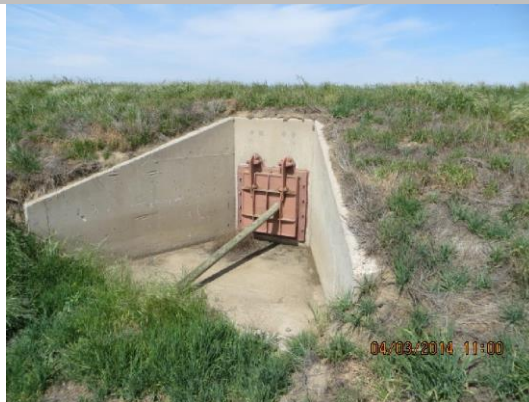
Photo 2 of 3 : UCIP_SP_2017_39545_59819.jpg

Flapgate on Concrete headwall at WS toe.

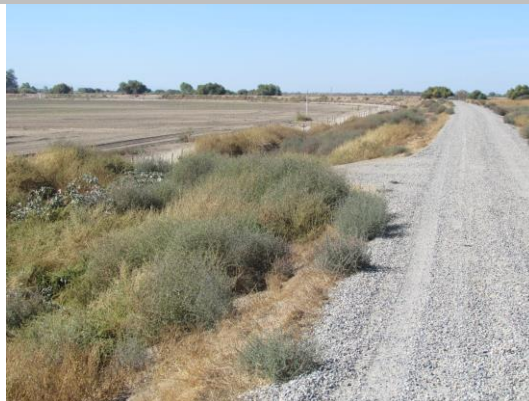
Photo 1 of 1 : SP_2017_NA0010_140_13_20170417_00005.jpg

LM Start	0.00	Rating **	M	Issue No.	13
LM End	5.85	Issue Type +	Ma	Location *	LS
Category	Earthen Levee			GPS Latitude/Longitude	
				Start	End
Item	Vegetation			36.773207 °	36.786728 °
				-120.285217 °	-120.218070 °
DWR ID	DWR_NA0010_24_f_2016_13				
Comment Code					
V1 : Control annual grass and weeds on the levee slopes and easements.					
Inspector Comment

Looking at typical view of dense veg on landward slope.

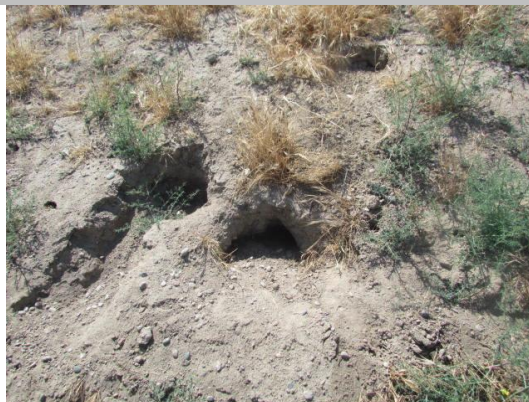
Photo 1 of 1 : SP_2017_NA0010_140_6_20170417_00002.jpg

LM Start	0.82	Rating **	M	Issue No.	6
LM End	0.82	Issue Type +	Ma	Location *	LS
Category	Earthen Levee			GPS Latitude/Longitude	
				Start	End
Item	Animal Control			36.766775 °	36.766775 °
				-120.278757 °	-120.278757 °
DWR ID	DWR_NA0010_24_s_2013_6				
Comment Code					
A1 : Exterminate rodents and backfill and compact or grout burrows.					
Inspector Comment					
Noted several rodent holes within this section.

Looking at several rodent holes on landward slope.

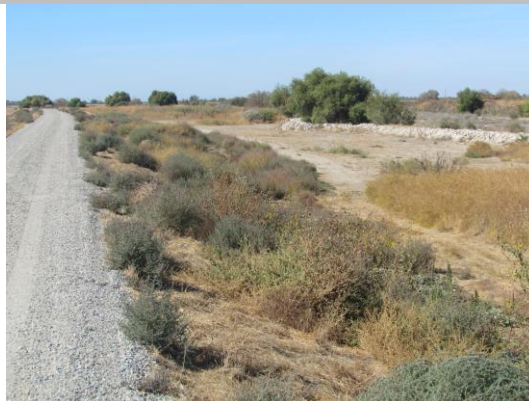
Photo 1 of 1 : SP_2017_NA0010_140_12_20170417_00004.jpg

LM Start	1.56	Rating **	M	Issue No.	12
LM End	8.35	Issue Type +	Ma	Location *	WS
Category	Earthen Levee			GPS Latitude/Longitude	
				Start	End
Item	Vegetation			36.770759 °	36.778347 °
				-120.269522 °	-120.184125 °
DWR ID	DWR_NA0010_24_f_2016_12				
Comment Code					
V1 : Control annual grass and weeds on the levee slopes and easements.					
Inspector Comment

Looking at typical view of dense veg on waterward slope.

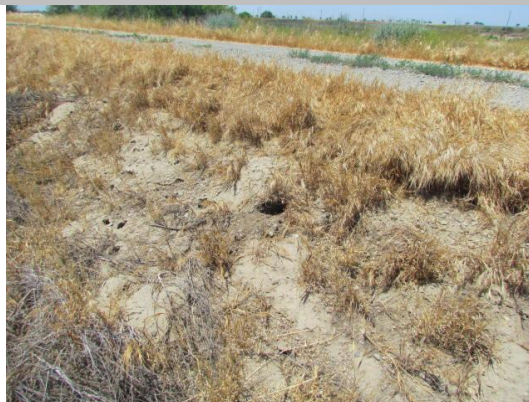
Photo 1 of 1 : SP_2017_NA0010_140_7_20170417_00003.jpg

LM Start	3.46	Rating **	M	Issue No.	7
LM End	3.46	Issue Type +	Ma	Location *	LS
Category	Earthen Levee			GPS Latitude/Longitude	
				Start	End
Item	Animal Control			36.769345 °	36.769345 °
				-120.238370 °	-120.238370 °
DWR ID	DWR_NA0010_24_s_2012_7				
Comment Code					
A3 : No rodents visible, but rodent burrows visible; need to backfill and compact or grout burrows.					
Inspector Comment					
One of several rodent holes on landward slope.

Looking east at one of several rodent holes on landward slope.

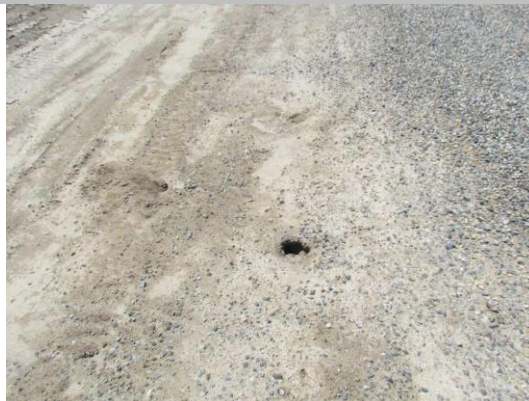
Photo 1 of 1 : SP_2017_NA0010_140_14_20170425_00031.jpg

LM Start	6.35	Rating **	M	Issue No.	14
LM End	6.35	Issue Type +	Ma	Location *	LS
Category	Earthen Levee			GPS Latitude/Longitude	
				Start	End
Item	Animal Control			36.788228 °	36.788228 °
				-120.209368 °	-120.209368 °
DWR ID	DWR_NA0010_24_s_2017_14				
Comment Code					
A3 : No rodents visible, but rodent burrows visible; need to backfill and compact or grout burrows.					
Inspector Comment					
Several rodent holes on levee landward shoulder and slope.

Looking at typical view of rodent holes within this section on landward shoulder and slope.

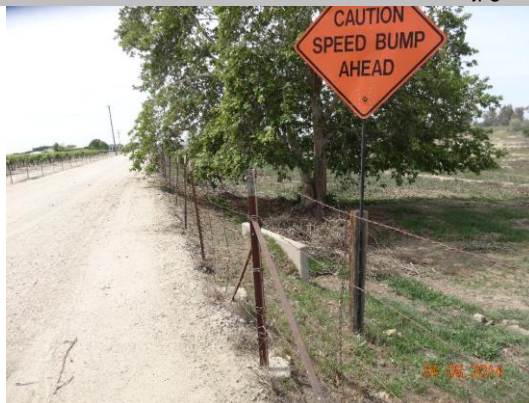
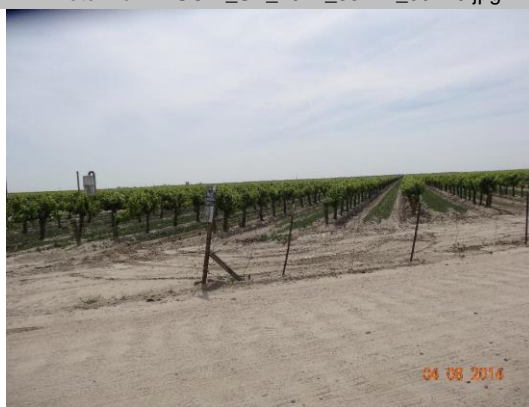
FS_ID:33272
DS_ID:19960
EP_NO: N/A
Repair Type: Non-Urgent
Crossing Status: Found
UCIP Comments: Barbed wire along levee shoulder--no access. Need to confirm crossing size and condition of crossing.
FIELD_STRUCT_DESC: 12-inch concrete pipe through the levee, 3.0 feet below the crown. Concrete headwall on the waterward end. Flap gate on the waterward end. (USACE-1967). This entry matches the Drainage or Irrigation Structure referenced in O&M manual (HLM 8.32).
FS Date: 4/8/2014

View of waterward side.

View of landward side.

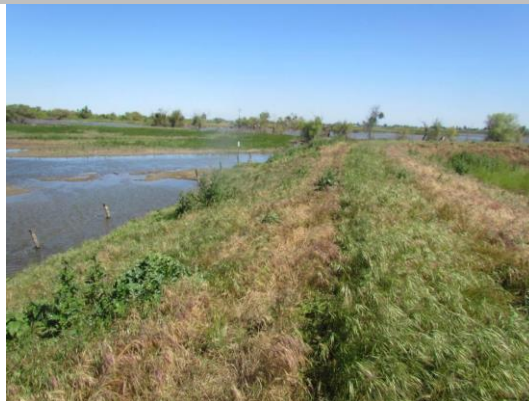
Photo 1 of 1 : SP_2017_NA0010_141_7_20170425_00025.jpg

LM Start	0.00	Rating **	U	Issue No.	7
LM End	2.48	Issue Type +	Ma	Location *	LS
Category	Earthen Levee			GPS Latitude/Longitude	
				Start	End
Item	Vegetation			37.296261 °	37.271165 °
				-120.880678 °	-120.866629 °
DWR ID	DWR_NA0010_25_f_2015_7				
Comment Code					
V2 : Remove the wild growth other than native grasses from the levee slopes.					
Inspector Comment

Looking at typical view of landward slope.

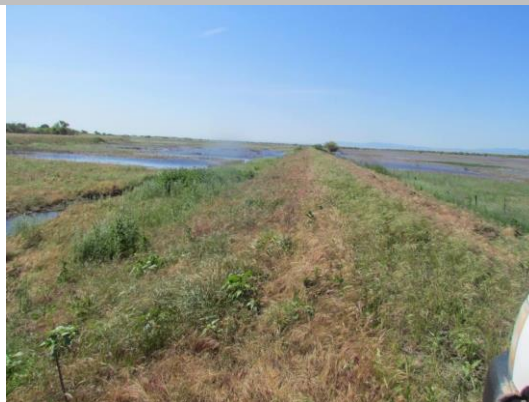
Photo 1 of 1 : SP_2017_NA0010_141_9_20170425_00026.jpg

LM Start	0.00	Rating **	U	Issue No.	9
LM End	2.49	Issue Type +	Ma	Location *	WS
Category	Earthen Levee			GPS Latitude/Longitude	
				Start	End
Item	Vegetation			37.296261 °	37.271117 °
				-120.880678 °	-120.866599 °
DWR ID	DWR_NA0010_25_f_2015_9				
Comment Code					
V2 : Remove the wild growth other than native grasses from the levee slopes.					
Inspector Comment

Looking typical view of waterward slope.

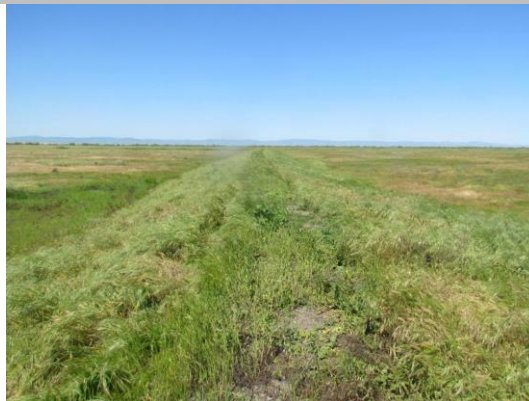
Photo 1 of 1 : SP_2017_NA0010_141_8_20170425_00027.jpg

LM Start	0.01	Rating **	U	Issue No.	8
LM End	1.76	Issue Type +	Ma	Location *	CR
Category	Earthen Levee			GPS Latitude/Longitude	
				Start	End
Item	Vegetation			37.296117 °	37.281615 °
				-120.880724 °	-120.867133 °
DWR ID	DWR_NA0010_25_s_2012_8				
Comment Code					
V2 : Remove the wild growth other than native grasses from the levee slopes.					
Inspector Comment					
Control weeds on levee crown.

Looking at typical view of levee crown.

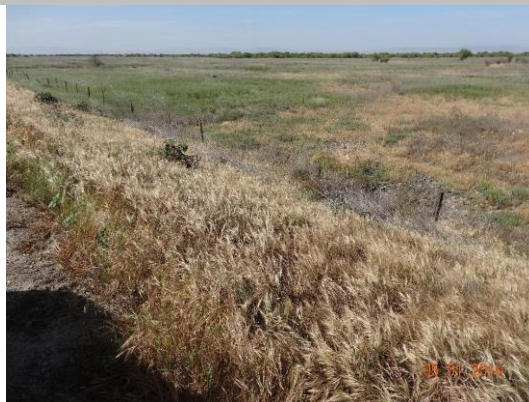
Photo 1 of 3 : UCIP_SP_2017_39501_67242.jpg

Comment Code					
Inspector Comment					
FS_ID:39501 DS_ID:19965 EP_NO: N/A Repair Type: Non-Urgent Crossing Status: Found UCIP Comments: Dense vegetation limits the inspectors visibility to identify signs of pipe failure (leaks) along the slope. Recommend removing vegetation along pipe alignment to conduct proper inspection of structure. Sediment buildup in pipe visible from landward side--recommend clearing. FIELD_STRUCT_DESC: 24-inch CM pipe through the levee, 10.0 feet below the crown. Flap gate on the waterward end. (USACE-1967). This entry matches the Drainage or Irrigation Structure referenced in O&M manual (HLM 0.02). FS Date: 5/1/2014

View of waterward side--dense vegetation on waterward side.

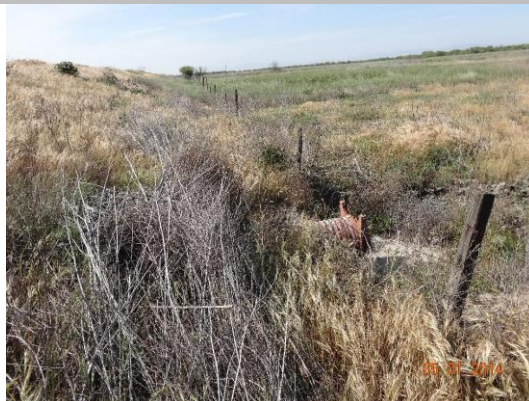
Photo 2 of 3 : UCIP_SP_2017_39501_67240.jpg

FS_ID:39501
DS_ID:19965
EP_NO: N/A
Repair Type: Non-Urgent
Crossing Status: Found
UCIP Comments: Dense vegetation limits the inspectors visibility to identify signs of pipe failure (leaks) along the slope. Recommend removing vegetation along pipe alignment to conduct proper inspection of structure. Sediment buildup in pipe visible from landward side--recommend clearing.
FIELD_STRUCT_DESC: 24-inch CM pipe through the levee, 10.0 feet below the crown. Flap gate on the waterward end. (USACE-1967). This entry matches the Drainage or Irrigation Structure referenced in O&M manual (HLM 0.02).
FS Date: 5/1/2014

Pipe daylight visible on waterward toe.

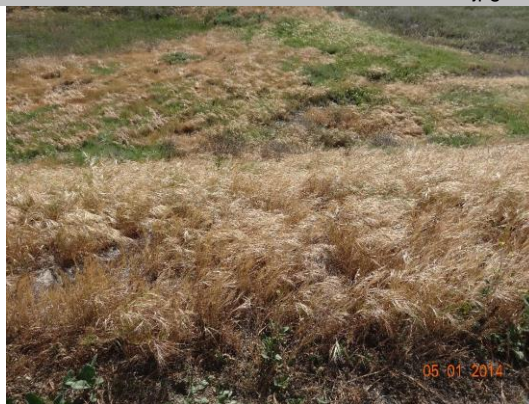
Photo 3 of 3 : UCIP_SP_2017_39501_67241.jpg

View of landward side--dense vegetation on landward side.

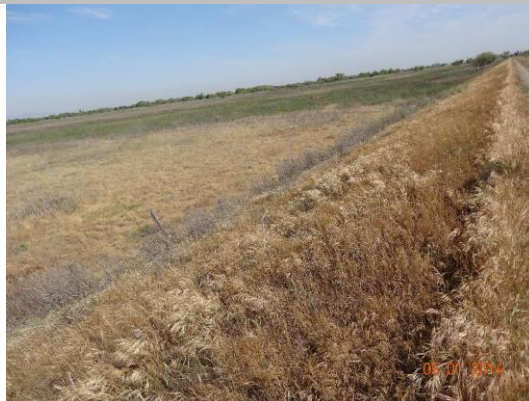
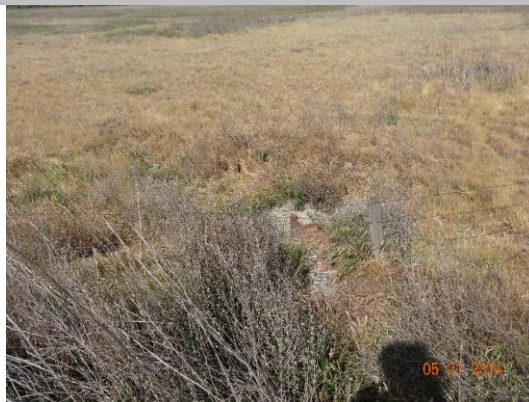
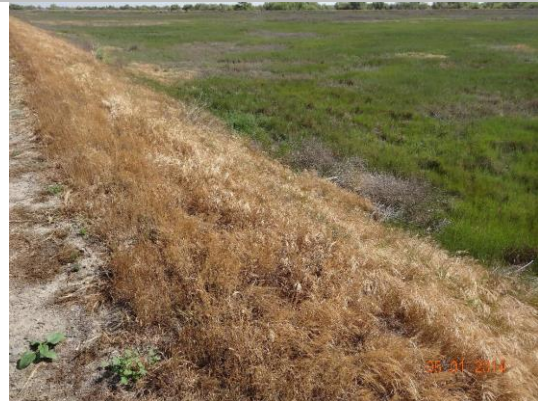
FS_ID:36851
DS_ID:19966
EP_NO: N/A
Repair Type: Non-Urgent
Crossing Status: Found
UCIP Comments: Dense vegetation limits the inspectors visibility to identify signs of pipe failure (leaks) along the slope. Recommend removing vegetation along pipe alignment to conduct proper inspection of structure.
FIELD_STRUCT_DESC: 24-inch CM pipe through the levee, 11.6 feet below the crown. Flap gate on the waterward end. (USACE-1967). This entry matches the Drainage or Irrigation Structure referenced in O&M manual (HLM 0.35).
FS Date: 5/1/2014

Pipe outlet visible on waterward side.

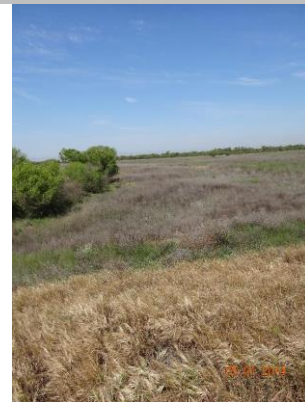
Photo 1 of 3 : UCIP_SP_2017_36852_67250.jpg

LM Start	0.59	Rating **	M	Issue No.	12
LM End	0.59	Issue Type +	Ma	Location *	CR
Category	Supplemental			GPS Latitude/Longitude	
				Start	End
Item	DWR UCIP LMA Responsibility			37.287744 °	37.287744 °
				-120.880645 °	-120.880645 °
DWR ID					
Comment Code					
Inspector Comment					
FS_ID:36852 DS_ID:19967 EP_NO: N/A Repair Type: Non-Urgent Crossing Status: Found UCIP Comments: Dense vegetation limits the inspectors visibility to identify signs of pipe failure (leaks) along the slope. Recommend removing vegetation along pipe alignment to conduct proper inspection of structure. FIELD_STRUCT_DESC: 24-inch CM pipe through the levee, 14.7 feet below the crown. Flap gate on the waterward end. (USACE-1967). This entry matches the Drainage or Irrigation Structure referenced in O&M manual (HLM 0.59). FS Date: 5/1/2014

Overview of waterward side--Salt Slough.

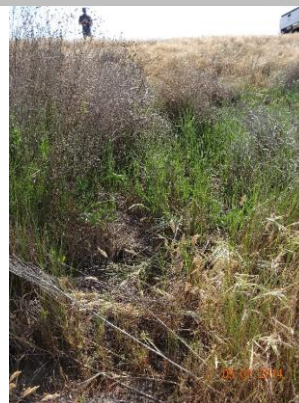
Photo 2 of 3 : UCIP_SP_2017_36852_67251.jpg

LM Start	0.59	Rating **	M	Issue No.	12 (cont)	
LM End	0.59	Issue Type +	Ma	Location *	CR	
Category	Supplemental			GPS Latitude/Longitude		
				Start		End
Item	DWR UCIP LMA Responsibility			37.287744 °		37.287744 °
				-120.880645 °		-120.880645 °
DWR ID						
Comment Code						
Inspector Comment						
FS_ID:36852						
DS_ID:19967						
EP_NO: N/A						
Repair Type: Non-Urgent						
Crossing Status: Found						
UCIP Comments: Dense vegetation limits the inspectors visibility to identify signs of pipe failure (leaks) along the slope. Recommend removing vegetation along pipe alignment to conduct proper inspection of structure.						
FIELD_STRUCT_DESC: 24-inch CM pipe through the levee, 14.7 feet below the crown. Flap gate on the waterward end. (USACE-1967). This entry matches the Drainage or Irrigation Structure referenced in O&M manual (HLM 0.59).						
FS Date: 5/1/2014

View of waterward slope covered by dense vegetation.

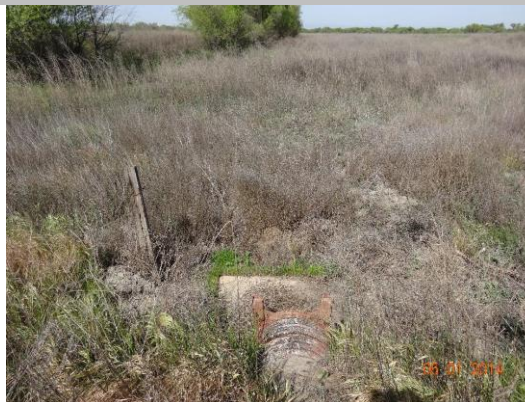
Photo 3 of 3 : UCIP_SP_2017_36852_67252.jpg

Pipe and flap gate visible on waterward side.

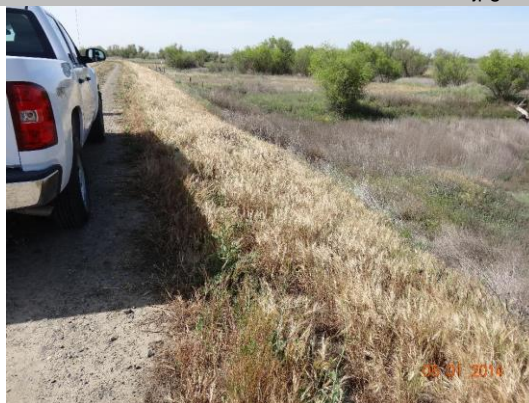
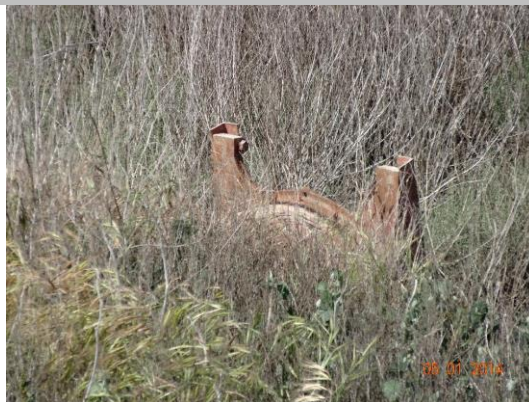
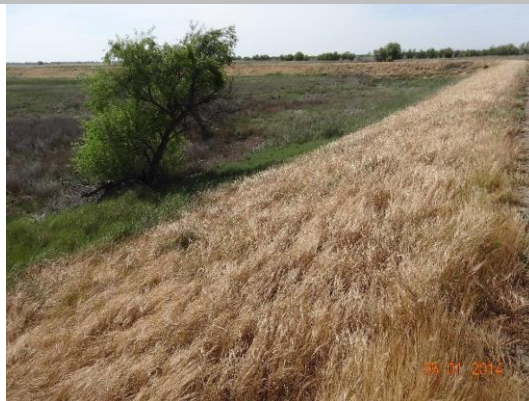
FS_ID:36853
DS_ID:19968
EP_NO: N/A
Repair Type: Non-Urgent
Crossing Status: Found
UCIP Comments: Dense vegetation limits the inspectors visibility to identify signs of pipe failure (leaks) along the slope. Recommend removing vegetation along pipe alignment to conduct proper inspection of structure.
FIELD_STRUCT_DESC: 24-inch CM pipe through the levee, 11.4 feet below the crown. Flap gate on the waterward end. (USACE-1967). This entry matches the Drainage or Irrigation Structure referenced in O&M manual (HLM 0.97).
FS Date: 5/1/2014

Pipe and evidence of flap gate visible on waterward side.

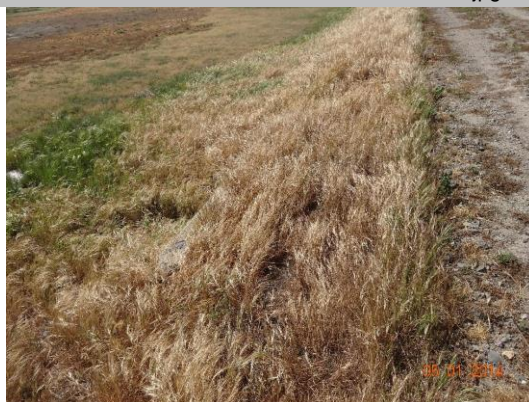
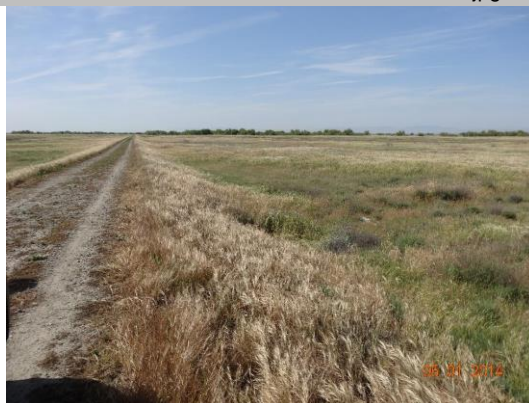
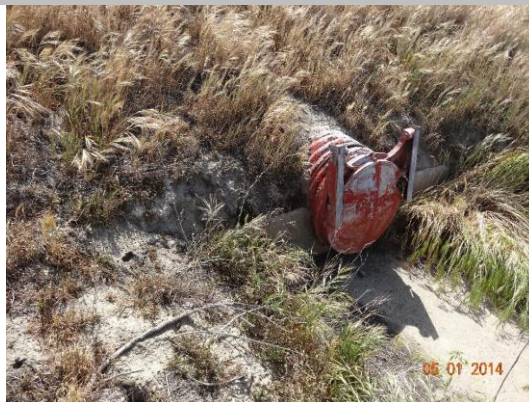
LM Start	2.05	Rating **	M	Issue No.	14
LM End	2.05	Issue Type +	Ma	Location *	CR
Category	Supplemental			GPS Latitude/Longitude	
				Start	End
Item	DWR UCIP LMA Responsibility			37.277390 °	37.277390 °
				-120.867184 °	-120.867184 °
DWR ID					
Comment Code					
Inspector Comment					
FS_ID:36854					
DS_ID:19969					
EP_NO: N/A					
Repair Type: Non-Urgent					
Crossing Status: Found					
UCIP Comments: Dense vegetation limits the inspectors visibility to identify signs of pipe failure (leaks) along the slope. Recommend removing vegetation along pipe alignment to conduct proper inspection of structure.					
FIELD_STRUCT_DESC: 24-inch CM pipe through the levee, 4.0 feet below the crown. Flap gate on the waterward end. (USACE-1967). This entry matches the Drainage or Irrigation Structure referenced in O&M manual (HLM 2.05).					
FS Date: 5/1/2014

Flap gate and concrete headwall located on waterward toe.

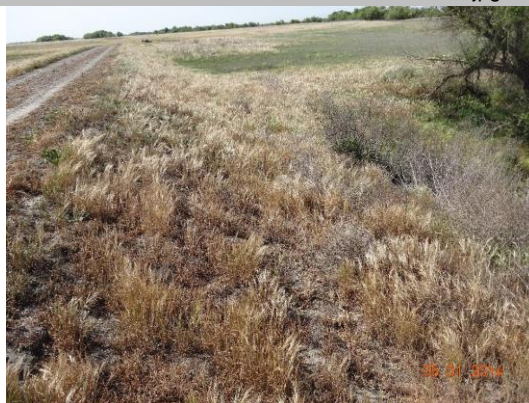
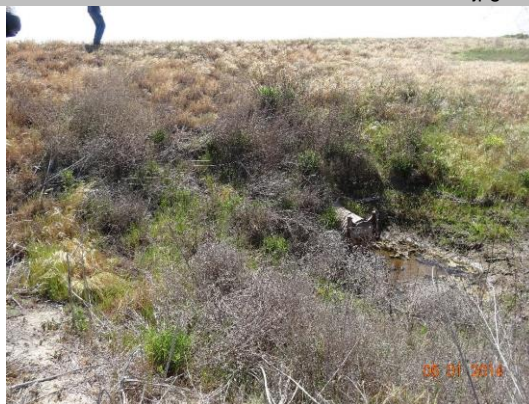
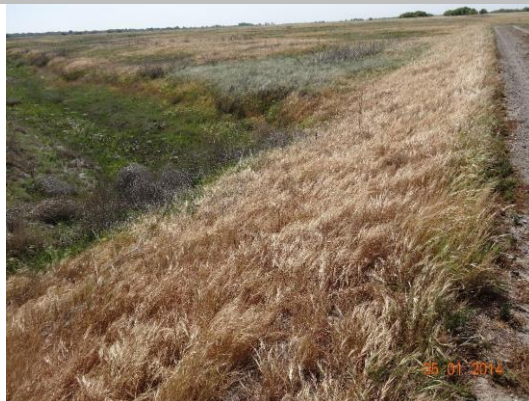
FS_ID:39502
DS_ID:19970
EP_NO: N/A
Repair Type: Non-Urgent
Crossing Status: Found
UCIP Comments: Dense vegetation limits the inspectors visibility to identify signs of pipe failure (leaks) along the slope. Recommend removing vegetation along pipe alignment to conduct proper inspection of structure. Sediment buildup in pipe visible on landward side-- recommend clearing.
FIELD_STRUCT_DESC: 24-inch CM pipe through the levee, 11.2 feet below the crown. Flap gate on the waterward end. (USACE-1967). This entry matches the Drainage or Irrigation Structure referenced in O&M manual (HLM 2.45).
FS Date: 5/1/2014 4:04:00 PM

Pipe daylights at waterward toe.

FS_ID:39502
 DS_ID:19970
 EP_NO: N/A
 Repair Type: Non-Urgent
 Crossing Status: Found
 UCIP Comments: Dense vegetation limits the inspectors visibility to identify signs of pipe failure (leaks) along the slope. Recommend removing vegetation along pipe alignment to conduct proper inspection of structure. Sediment buildup in pipe visible on landward side-- recommend clearing.
 FIELD_STRUCT_DESC: 24-inch CM pipe through the levee, 11.2 feet below the crown. Flap gate on the waterward end. (USACE-1967). This entry matches the Drainage or Irrigation Structure referenced in O&M manual (HLM 2.45).
 FS Date: 5/1/2014 4:04:00 PM
