**Flood Control Project Maintenance  
Levee Inspections**

## Maintenance Issue Types Only, Levee Inspection Report By Mile - Spring 2018

### Lower San Joaquin Levee District

Waterway	Bank	Unit Miles	Inspection Start/End	Inspector
Unit No. 01 San Joaquin River	Right	22.52	04/04/2018 04/16/2018	Richard Willoughby

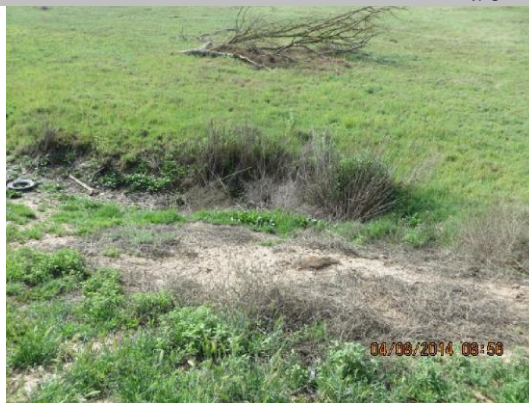
Item	DWR UCIP LMA Responsibility		37.348637 °	37.348637 °	
			-120.958834 °	-120.958834 °	
DWR ID					
Comment Code					
Inspector Comment					
FS_ID:39091 DS_ID:19650 EP_NO: N/A Repair Type: Non-Urgent Crossing Status: Found UCIP Comments: Dense vegetation limits the inspector's visibility to identify signs of pipe failure (leaks) along the waterward slope and landward toe. Recommend removing vegetation along pipe alignment and landward toe to conduct proper inspection of structure and appurtenances. FIELD_STRUCT_DESC: 24-inch corrugated metal gravity drainage pipe through the levee, 10.5 feet below the crown. Flap gate on the waterside (WS) end. Brass cap No. 108 bench mark (BM) on the headwall on the landside (LS), elevation 65.1 feet, USGS Datum. [Additional Reference(s): DWR Levee Log, 2002. USACE San Joaquin O&M Manual 601.1, 1967, (HLM 0.02)]. FS Date: 4/8/2014 7:34:00 AM

Flapgate on WS toe.

Headwall on LS toe.

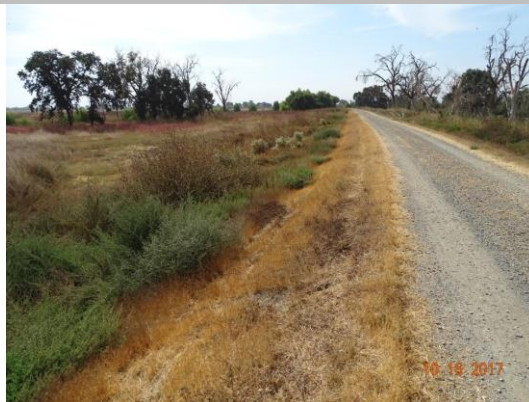
Photo 1 of 1 : SP\_2018\_NA0010\_118\_102\_20180307\_00018.jpg

LM Start	0.06	Rating **	A/W	Issue No.	102
LM End	0.27	Issue Type +	Ma	Location *	LS
Category	Earthen Levee			GPS Latitude/Longitude	
				Start	End
Item	Vegetation			37.348139 °	37.345556 °
				-120.959688 °	-120.961795 °
DWR ID	DWR_NA0010_01_f _ 2017_102				
Comment Code					
V2 : Remove the wild growth other than native grasses from the levee slopes.					
Inspector Comment					
Dense vegetation at the landside toe.

Looking southwest at the landside slope.

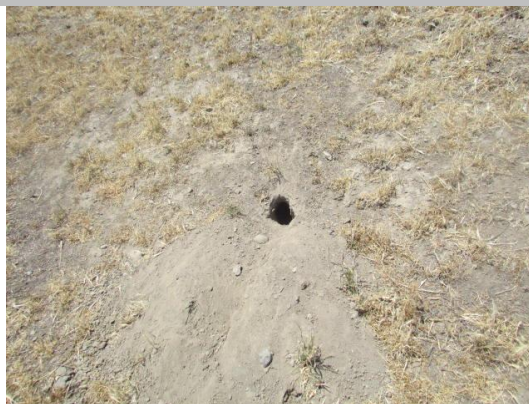
Photo 1 of 1 : SP\_2018\_NA0010\_118\_1\_20180307\_00001.jpg

LM Start	0.07	Rating **	M	Issue No.	1
LM End	0.23	Issue Type +	Ma	Location *	LS
Category	Earthen Levee			GPS Latitude/Longitude	
				Start	End
Item	Animal Control			37.347999 °	37.346096 °
				-120.959840 °	-120.961455 °
DWR ID	DWR_NA0010_01_s_2012_1				
Comment Code					
A1 : Exterminate rodents and backfill and compact or grout burrows.					
Inspector Comment					
Typical view of several rodent holes on landward slope.Could not see rodent holes due to dense vegetation.

Looking at typical rodent holes on landward slope.

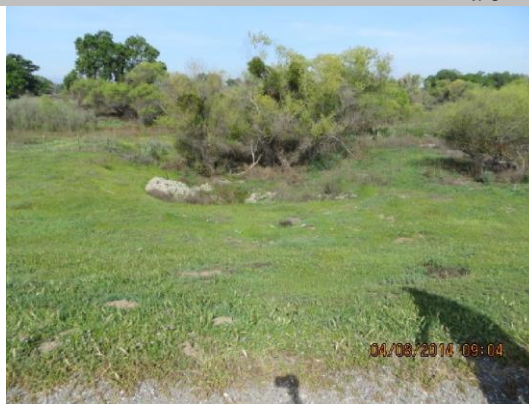
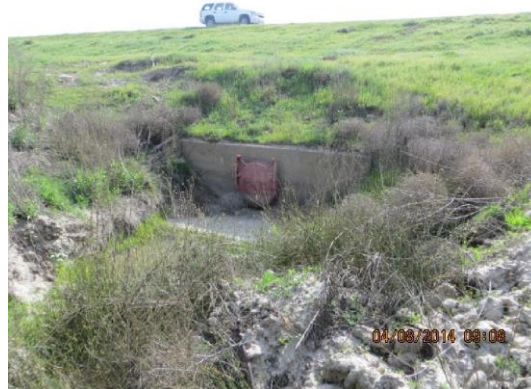
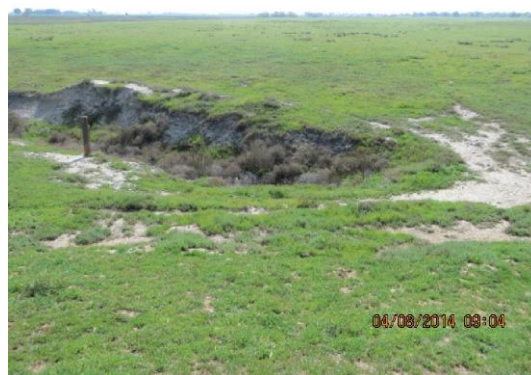
Flapgate and headwall visible off WS toe.

FS\_ID:39092  
DS\_ID:19651  
EP\_NO: N/A  
Repair Type: Non-Urgent  
Crossing Status: Found  
UCIP Comments: Pipe has significant sediment buildup and shows some signs of corrosion at landward toe. Recommend cleaning sediment from inside pipe and check wall integrity.  
FIELD\_STRUCT\_DESC: 36-inch corrugated metal gravity drainage pipe through the levee, 18.5 feet below the crown. Flap gate on the waterside (WS) end. Brass cap No. 108 bench mark (BM) on the headwall on the landside (LS). [Additional Reference(s): DWR Levee Log, 2002. USACE San Joaquin O&M Manual 601.1, 1967, (HLM 0.35)].  
FS Date: 4/8/2014

Pipe and headwall visible off LS toe.

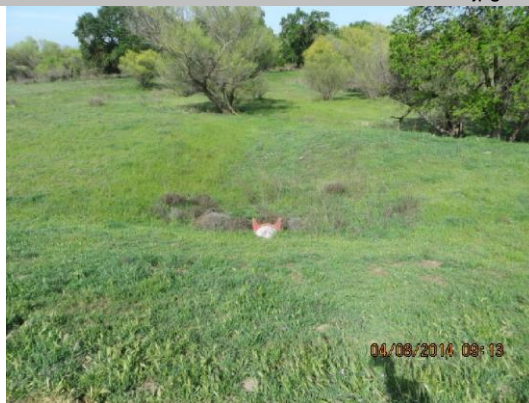
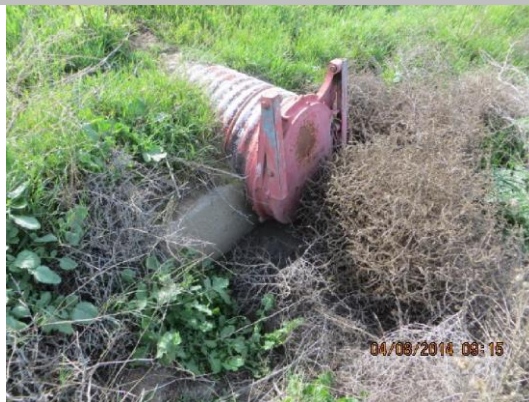
LM Start	0.60	Rating **	M	Issue No.	1187	
LM End	0.60	Issue Type +	Ma	Location *		
Category	Supplemental			GPS Latitude/Longitude		
				Start	End	
Item	DWR UCIP LMA Responsibility			37.341507 °	37.341507 °	
				-120.961283 °	-120.961283 °	
DWR ID						
Comment Code						
Inspector Comment						
FS_ID:39095						
DS_ID:19583						
EP_NO: N/A						
Repair Type: Non-Urgent						
Crossing Status: Found						
UCIP Comments: Recommend removing vegetation pile from waterward toe.						
FIELD_STRUCT_DESC: 24-inch corrugated metal gravity drainage pipe through the levee, 8.5 feet below the crown. Flap gate on the waterside (WS) end. Brass cap No. 108 bench mark (BM) on the headwall on the landside (LS). [Additional Reference(s): DWR Levee Log, 2002. USACE San Joaquin O&M Manual 601.1, 1967, (HLM 0.62)].						
FS Date: 4/8/2014

Flapgate and headwall visible on WS toe.

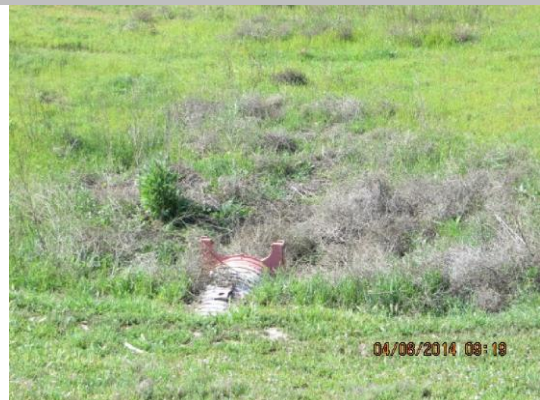
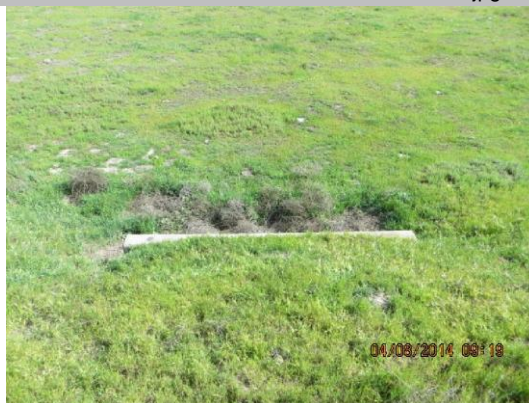
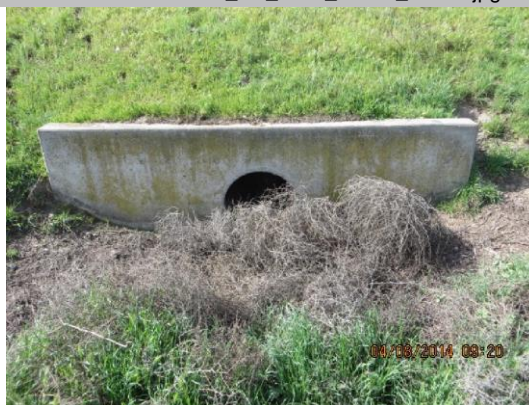
LM Start	0.85	Rating **	A/W	Issue No.	1188
LM End	0.85	Issue Type +	Ma	Location *	
Category	Supplemental			GPS Latitude/Longitude	
				Start	End
Item	DWR UCIP LMA Responsibility			37.339829 °	37.339829 °
				-120.958621 °	-120.958621 °
DWR ID					
Comment Code					
Inspector Comment					
FS_ID:33524					
DS_ID:19584					
EP_NO: N/A					
Repair Type: No Action Needed					
Crossing Status: Found					
UCIP Comments:					
FIELD_STRUCT_DESC: 24-inch corrugated metal gravity drainage pipe through the levee, 7 feet below the crown. Flap gate on the waterside (WS) end. Brass cap No. 108 bench mark (BM) on the headwall on the landside (LS). [Additional Reference(s): DWR Levee Log, 2002. USACE San Joaquin O&M Manual 601.1, 1967, (HLM 0.87)].					
FS Date: 4/8/2014

Pipe, flapgate, and headwall visible on WS toe.

Pipe and headwall visible on LS toe.

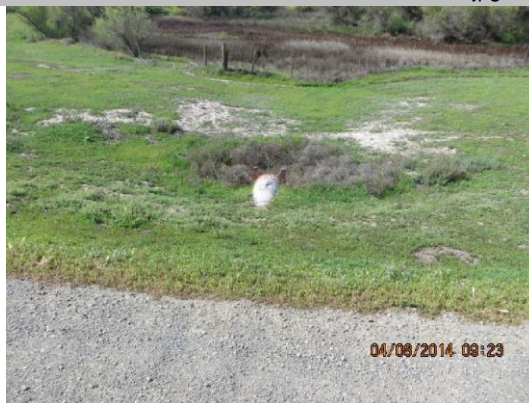
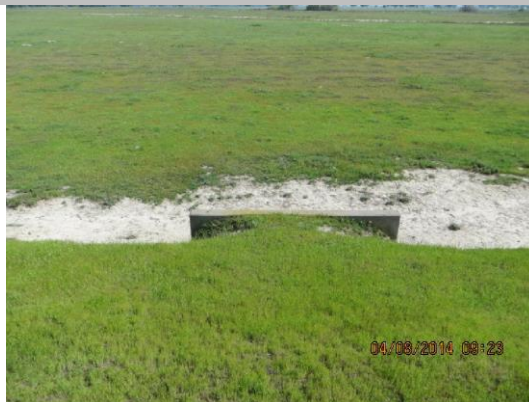
Comment Code						
Inspector Comment						
FS_ID:39096						
DS_ID:19585						
EP_NO: N/A						
Repair Type: Non-Urgent						
Crossing Status: Found						
UCIP Comments: Moderate erosion around headwall on landward toe.						
May or may not be an issue. Need to contact owner to determine status						
of crossing and to address erosion issue on landward side.						
FIELD_STRUCT_DESC: 24-inch corrugated metal gravity drainage pipe						
through the levee, 7 feet below the crown. Flap gate on the waterside						
(WS) end. Brass cap No. 108 bench mark (BM) on the headwall on the						
landside (LS). [Additional Reference(s): DWR Levee Log, 2002. USACE						
San Joaquin O&M Manual 601.1, 1967, (HLM 0.95)].						
FS Date: 4/8/2014

Flapgate, pipe, and headwall on WS toe.

Concrete headwall and pipe visible at LS toe.

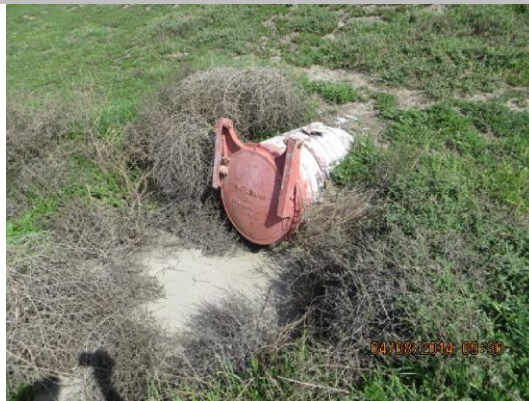
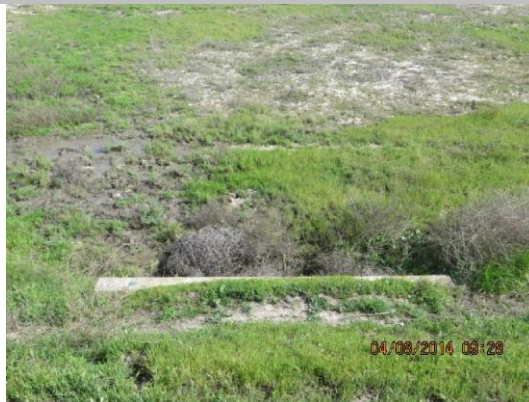
LM Start	1.15	Rating **	A/W	Issue No.	1190 (cont)	
LM End	1.15	Issue Type +	Ma	Location *		
Category	Supplemental			GPS Latitude/Longitude		
				Start	End	
Item	DWR UCIP LMA Responsibility			37.338005 °	37.338005 °	
				-120.953921 °	-120.953921 °	
DWR ID						
Comment Code						
Inspector Comment						
FS_ID:33543						
DS_ID:19586						
EP_NO: N/A						
Repair Type: No Action Needed						
Crossing Status: Found						
UCIP Comments:						
FIELD_STRUCT_DESC: 24-inch corrugated metal gravity drainage pipe						
through the levee, 7.5 feet below the crown. Flap gate on the waterside						
(WS) end. Brass cap No. 108 bench mark (BM) on the headwall on the						
landside (LS). [Additional Reference(s): DWR Levee Log, 2002. USACE						
San Joaquin O&M Manual 601.1, 1967, (HLM 1.17)].						
FS Date: 4/8/2014

Pipe, headwall, and flapgate visible on WS toe.

Headwall and pipe visible on LS toe.

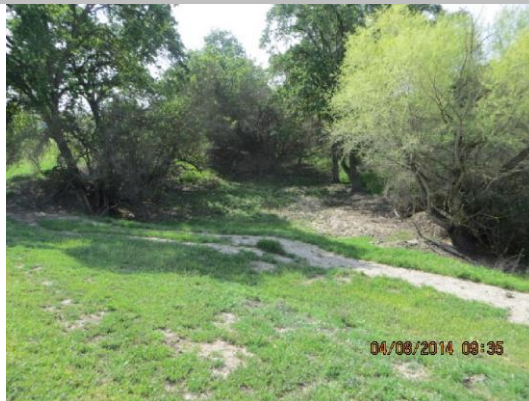
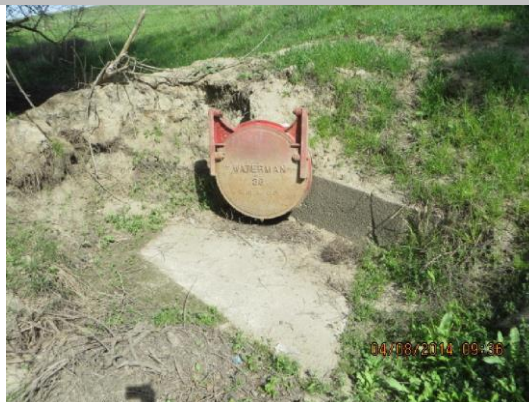
LM Start	1.32	Rating **	A/W	Issue No.	1191
LM End	1.32	Issue Type +	Ma	Location *	
Category	Supplemental			GPS Latitude/Longitude	
				Start	End
Item	DWR UCIP LMA Responsibility			37.337361 °	37.337361 °
				-120.950879 °	-120.950879 °
DWR ID					
Comment Code					
Inspector Comment					
FS_ID:33544 DS_ID:19587 EP_NO: N/A Repair Type: No Action Needed Crossing Status: Found UCIP Comments: FIELD_STRUCT_DESC: 36-inch corrugated metal gravity drainage pipe through the levee, 12.8 feet below the crown. Flap gate on the waterside (WS) end. Brass cap No. 108 bench mark (BM) on the headwall on the landside (LS). Pipe crosses through the levee at about a 45 degree angle to the crown. [Additional Reference(s): DWR Levee Log, 2002. USACE San Joaquin O&M Manual 601.1, 1967, (HLM 1.34)]. FS Date: 4/8/2014

Concrete headwall and flapgate visible at WS toe.

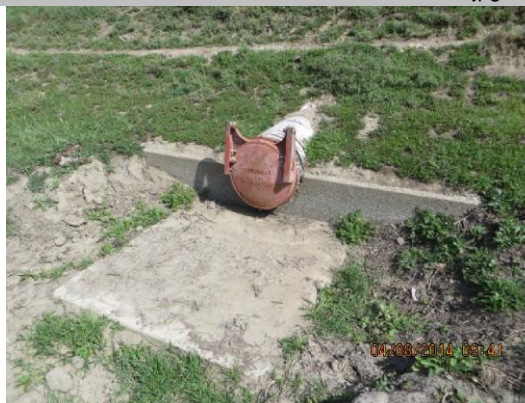
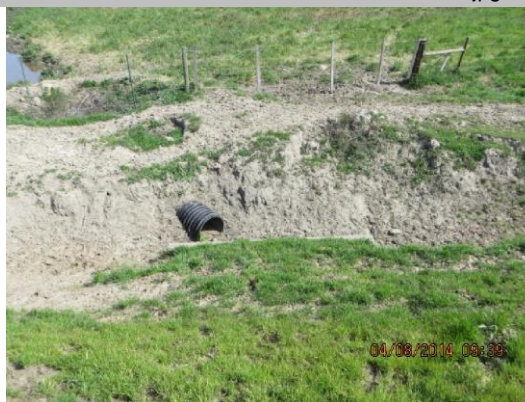
Comment Code					
Inspector Comment					
FS_ID:39099					
DS_ID:19588					
EP_NO: N/A					
Repair Type: Non-Urgent					
Crossing Status: Found					
UCIP Comments: Some sediment buildup inside pipe at LS toe.					
Recommend contacting owner to clear sediment buildup and check wall integrity through pipe section.					
FIELD_STRUCT_DESC: 24-inch corrugated metal gravity drainage pipe through the levee, 11 feet below the crown. Flap gate on the waterside (WS) end. Brass cap No. 108 bench mark (BM) on the headwall on the landside (LS). [Additional Reference(s): DWR Levee Log, 2002. USACE San Joaquin O&M Manual 601.1, 1967, (HLM 1.48)].					
FS Date: 4/8/2014

Pipe, flapgate, and concrete headwall visible on WS toe.

Pipe and concrete headwall visible on LS toe.

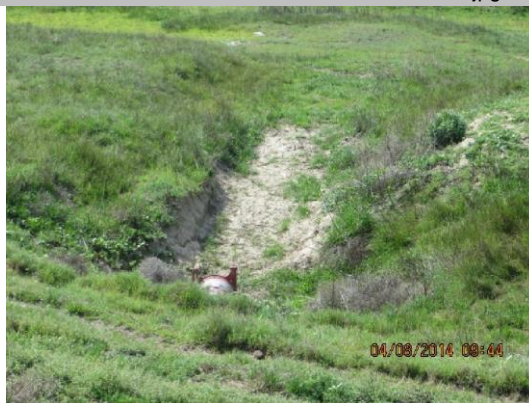
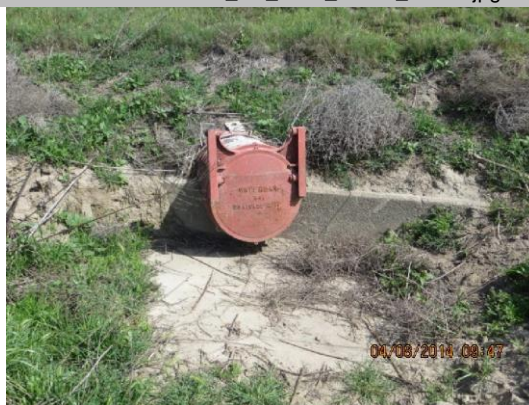
LM Start	1.67	Rating **	M	Issue No.	1193	
LM End	1.67	Issue Type +	Ma	Location *		
Category	Supplemental			GPS Latitude/Longitude		
				Start	End	
Item	DWR UCIP LMA Responsibility			37.336459 °	37.336459 °	
				-120.944803 °	-120.944803 °	
DWR ID						
Comment Code						
Inspector Comment						
FS_ID:33563 DS_ID:19589 EP_NO: N/A Repair Type: Non-Urgent Crossing Status: Found UCIP Comments: Heavy sediment buildup in pipe at LS toe. FIELD_STRUCT_DESC: 24-inch corrugated metal gravity drainage pipe through the levee, 13.6 feet below the crown. Flap gate on the waterside (WS) end. Brass cap No. 108 bench mark (BM) on the headwall on the landside (LS). [Additional Reference(s): DWR Levee Log, 2002. USACE San Joaquin O&M Manual 601.1, 1967, (HLM 1.69)]. FS Date: 4/8/2014

Pipe, headwall, and flapgate visible on WS toe.

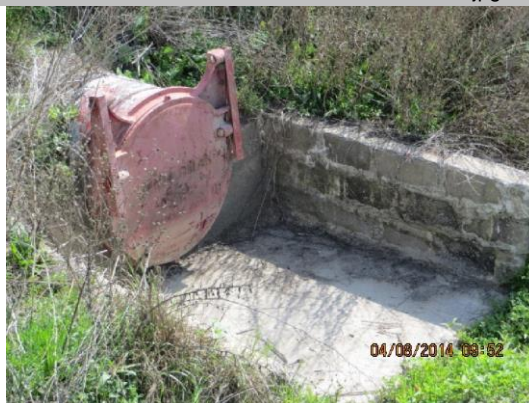
Photo 2 of 3 : UCIP\_SP\_2018\_33564\_60667.jpg

LM Start	1.81	Rating **	A/W	Issue No.	1194 (cont)	
LM End	1.81	Issue Type +	Ma	Location *		
Category	Supplemental			GPS Latitude/Longitude		
				Start	End	
Item	DWR UCIP LMA Responsibility			37.335612 °	37.335612 °	
				-120.942532 °	-120.942532 °	
DWR ID						
Comment Code						
Inspector Comment						
FS_ID:33564						
DS_ID:19590						
EP_NO: N/A						
Repair Type: No Action Needed						
Crossing Status: Found						
UCIP Comments:						
FIELD_STRUCT_DESC: 36-inch corrugated metal gravity drainage pipe						
through the levee, 14.2 feet below the crown. Flap gate on the						
waterside (WS) end. Brass cap No. 100 bench mark (BM) on the						
headwall on the landside (LS). [Additional Reference(s): DWR Levee						
Log, 2002. USACE San Joaquin O&M Manual 601.1, 1967, (HLM 1.83)].						
FS Date: 4/8/2014

Pipe, flapgate, and headwall visible at WS toe.

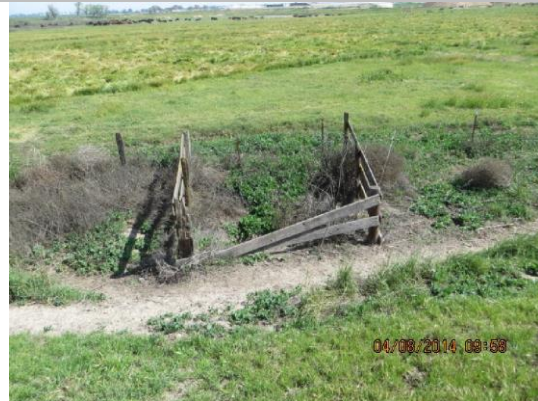
Photo 3 of 3 : UCIP\_SP\_2018\_39100\_60671.jpg

LM Start	1.95	Rating **	M	Issue No.	1195 (cont)
LM End	1.95	Issue Type +	Ma	Location *	
Category	Supplemental			GPS Latitude/Longitude	
				Start	End
Item	DWR UCIP LMA Responsibility			37.334377 °	37.334377 °
				-120.940397 °	-120.940397 °
DWR ID					
Comment Code					
Inspector Comment					
FS_ID:39100 DS_ID:19591 EP_NO: N/A Repair Type: Non-Urgent Crossing Status: Found UCIP Comments: Need to contact owner to determine crossing status. Inlet drop box silted in and needs to be cleaned out. FIELD_STRUCT_DESC: 24-inch corrugated metal gravity drainage pipe through the levee, 9.7 feet below the crown. Flap gate on the waterside (WS) end. Brass cap No. 100 bench mark (BM) on the headwall on the landside (LS). Wooden barrier around drop inlet on the LS toe. [Additional Reference(s): DWR Levee Log, 2002. USACE San Joaquin O&M Manual 601.1, 1967, (HLM 1.98)]. FS Date: 4/8/2014

Wooded barrier around drop-inlet on LS toe.

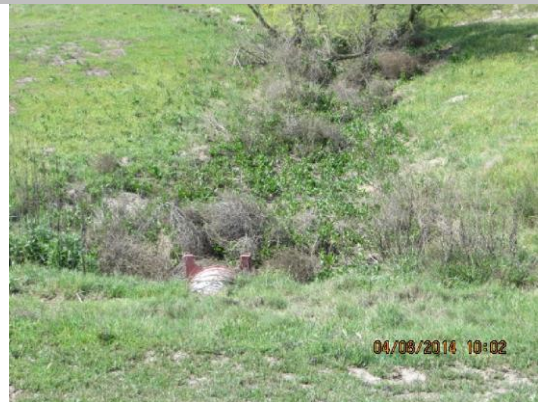
Photo 1 of 3 : UCIP\_SP\_2018\_39123\_60675.jpg

LM Start	2.06	Rating **	M	Issue No.	1196
LM End	2.06	Issue Type +	Ma	Location *	
Category	Supplemental			GPS Latitude/Longitude	
				Start	End
Item	DWR UCIP LMA Responsibility			37.333653 °	37.333653 °
				-120.938770 °	-120.938770 °
DWR ID					
Comment Code					
Inspector Comment					
FS_ID:39123 DS_ID:19570 EP_NO: N/A Repair Type: Non-Urgent Crossing Status: Found UCIP Comments: Unable to find inlet on landward toe. Recommend clearing vegetation on landward side to properly inspect inlet. FIELD_STRUCT_DESC: 24-inch corrugated metal gravity drainage pipe through the levee, 9.8 feet below the crown. Flap gate on the waterside (WS) end. Brass cap No. 100 bench mark (BM) on the headwall on the landside (LS). [Additional Reference(s): DWR Levee Log, 2002. USACE San Joaquin O&M Manual 601.1, 1967, (HLM 2.08)]. FS Date: 4/8/2014

Pipe and flapgate visible on WS toe.

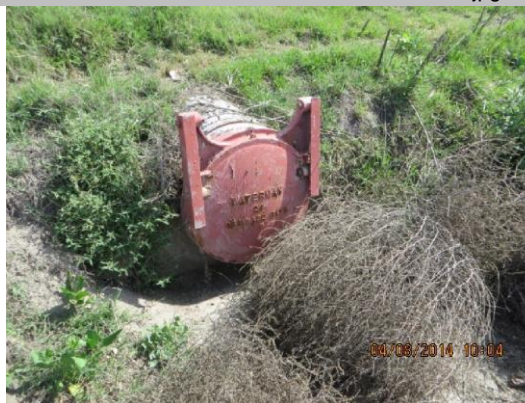
Photo 2 of 3 : UCIP\_SP\_2018\_39123\_60676.jpg

LM Start	2.06	Rating **	M	Issue No.	1196 (cont)	
LM End	2.06	Issue Type +	Ma	Location *		
Category	Supplemental			GPS Latitude/Longitude		
				Start	End	
Item	DWR UCIP LMA Responsibility			37.333653 °	37.333653 °	
				-120.938770 °	-120.938770 °	
DWR ID						
Comment Code						
Inspector Comment						
FS_ID:39123 DS_ID:19570 EP_NO: N/A Repair Type: Non-Urgent Crossing Status: Found UCIP Comments: Unable to find inlet on landward toe. Recommend clearing vegetation on landward side to properly inspect inlet. FIELD_STRUCT_DESC: 24-inch corrugated metal gravity drainage pipe through the levee, 9.8 feet below the crown. Flap gate on the waterside (WS) end. Brass cap No. 100 bench mark (BM) on the headwall on the landside (LS). [Additional Reference(s): DWR Levee Log, 2002. USACE San Joaquin O&M Manual 601.1, 1967, (HLM 2.08)]. FS Date: 4/8/2014

Pipe and flapgate visible on WS toe.

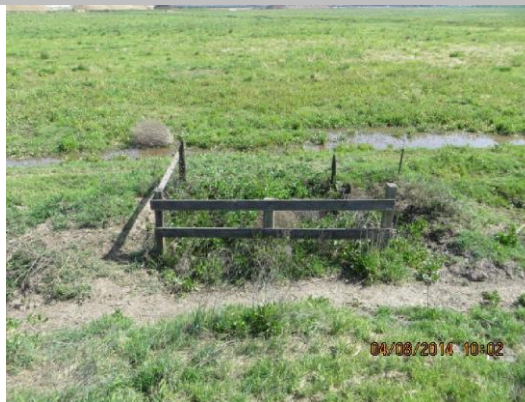
Photo 3 of 3 : UCIP\_SP\_2018\_39123\_60674.jpg

Wooded barrier around drop-inlet on LS toe.

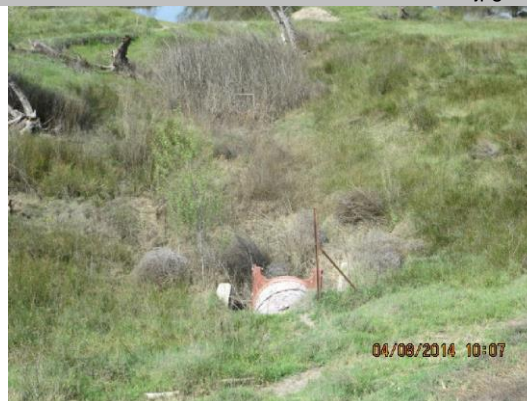
Photo 1 of 3 : UCIP\_SP\_2018\_39125\_71309.jpg

FS\_ID:39125  
DS\_ID:19571  
EP\_NO: N/A  
Repair Type: No Action Needed  
Crossing Status: Found  
UCIP Comments:  
FIELD\_STRUCT\_DESC: 36-inch corrugated metal gravity drainage pipe through the levee, 12.6 feet below the crown. Flap gate on the waterside (WS) end. Brass cap No. 100 bench mark (BM) on the headwall on the landside (LS). Wooden barrier around drop inlet on the LS toe. [Additional Reference(s): DWR Levee Log, 2002. USACE San Joaquin O&M Manual 601.1, 1967, (HLM 2.25)].  
FS Date: 4/8/2014

Pipe and flapgate on WS toe.

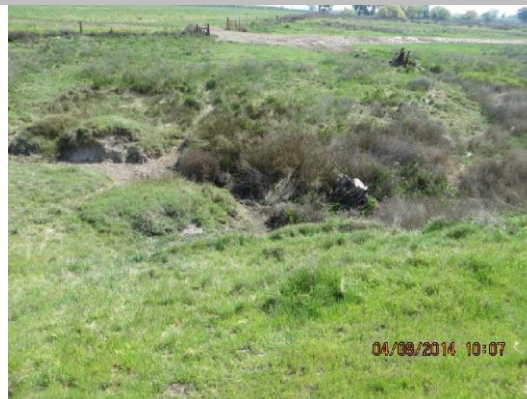
Photo 2 of 3 : UCIP\_SP\_2018\_39125\_71308.jpg

Pipe and headwall on LS toe.

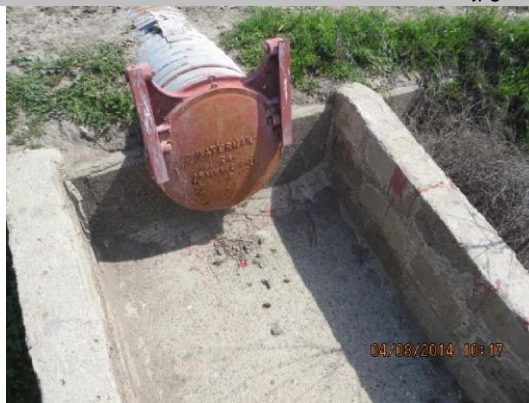
Photo 2 of 3 : UCIP\_SP\_2018\_33568\_60680.jpg

LM Start	2.50	Rating **	A/W	Issue No.	1198 (cont)	
LM End	2.50	Issue Type +	Ma	Location *		
Category	Supplemental			GPS Latitude/Longitude		
				Start	End	
Item	DWR UCIP LMA Responsibility			37.328619 °	37.328619 °	
				-120.934369 °	-120.934369 °	
DWR ID						
Comment Code						
Inspector Comment						
FS_ID:33568						
DS_ID:19572						
EP_NO: N/A						
Repair Type: No Action Needed						
Crossing Status: Found						
UCIP Comments:						
FIELD_STRUCT_DESC: 24-inch corrugated metal gravity drainage pipe						
through the levee, 8 feet below the crown. Flap gate on the waterside						
(WS) end. Brass cap No. 100 bench mark (BM) on the headwall on the						
landside (LS). [Additional Reference(s): DWR Levee Log, 2002. USACE						
San Joaquin O&M Manual 601.1, 1967, (HLM 2.52)].						
FS Date: 4/8/2014

Pipe, headwall, and flapgate on WS toe.

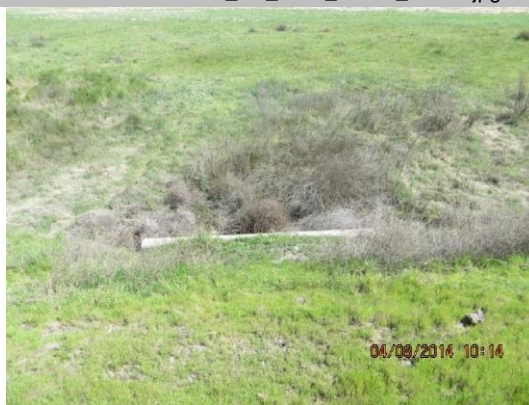
Photo 3 of 3 : UCIP\_SP\_2018\_33568\_60678.jpg

Pipe and headwall on LS toe.

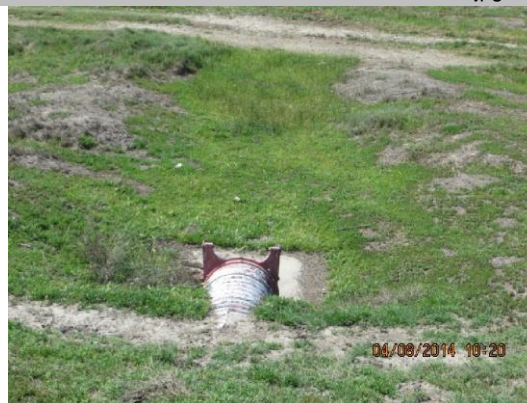
Photo 1 of 3 : UCIP\_SP\_2018\_39127\_60688.jpg

LM Start	2.67	Rating **	M	Issue No.	1199	
LM End	2.67	Issue Type +	Ma	Location *		
Category	Supplemental			GPS Latitude/Longitude		
				Start	End	
Item	DWR UCIP LMA Responsibility			37.327362 °	37.327362 °	
				-120.931591 °	-120.931591 °	
DWR ID						
Comment Code						
Inspector Comment						
FS_ID:39127						
DS_ID:19573						
EP_NO: N/A						
Repair Type: Non-Urgent						
Crossing Status: Found						
UCIP Comments: Sedimentation in pipe at landward toe.						
FIELD_STRUCT_DESC: 24-inch corrugated metal gravity drainage pipe						
through the levee, 7.3 feet below the crown. Flap gate on the waterside						
(WS) end. Brass cap No. 100 bench mark (BM) on the headwall on the						
landside (LS). [Additional Reference(s): DWR Levee Log, 2002. USACE						
San Joaquin O&M Manual 601.1, 1967, (HLM 2.70)].						
FS Date: 4/8/2014

Pipe, flapgate, and headwall on WS toe.

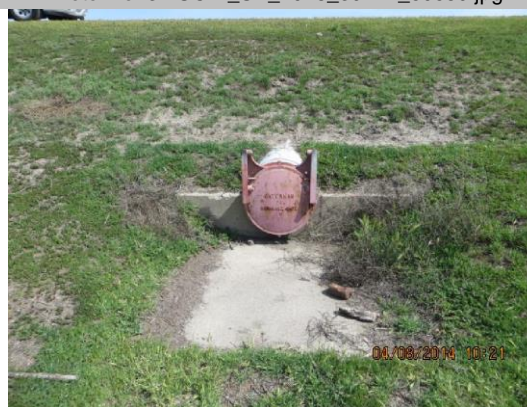
Photo 2 of 3 : UCIP\_SP\_2018\_39127\_60689.jpg

Pipe, flapgate, and headwall on WS toe.

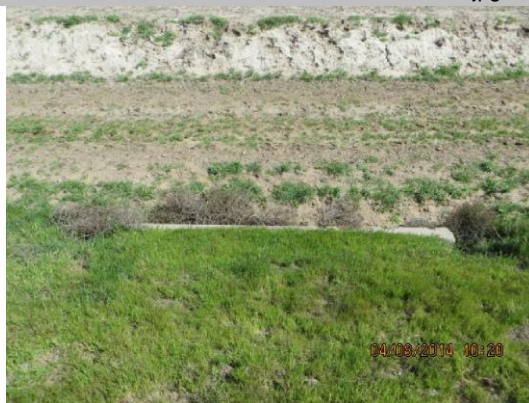
Photo 3 of 3 : UCIP\_SP\_2018\_39127\_60687.jpg

LM Start	2.67	Rating **	M	Issue No.	1199 (cont)	
LM End	2.67	Issue Type +	Ma	Location *		
Category	Supplemental			GPS Latitude/Longitude		
				Start	End	
Item	DWR UCIP LMA Responsibility			37.327362 °	37.327362 °	
				-120.931591 °	-120.931591 °	
DWR ID						
Comment Code						
Inspector Comment						
FS_ID:39127 DS_ID:19573 EP_NO: N/A Repair Type: Non-Urgent Crossing Status: Found UCIP Comments: Sedimentation in pipe at landward toe. FIELD_STRUCT_DESC: 24-inch corrugated metal gravity drainage pipe through the levee, 7.3 feet below the crown. Flap gate on the waterside (WS) end. Brass cap No. 100 bench mark (BM) on the headwall on the landside (LS). [Additional Reference(s): DWR Levee Log, 2002. USACE San Joaquin O&M Manual 601.1, 1967, (HLM 2.70)]. FS Date: 4/8/2014

Pipe and headwall on LS toe.

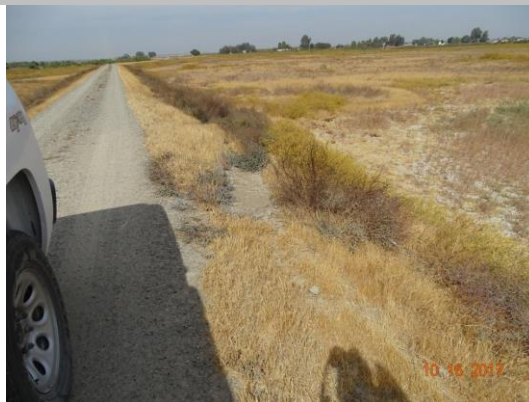
Photo 1 of 1 : SP\_2018\_NA0010\_118\_104\_20180307\_00019.jpg

LM Start	3.06	Rating **	M	Issue No.	104
LM End	3.06	Issue Type +	Ma	Location *	LS
Category	Earthen Levee			GPS Latitude/Longitude	
				Start	End
Item	Slope Stability			37.322499 °	37.322499 °
				-120.928986 °	-120.928986 °
DWR ID	DWR_NA0010_01_f_2017_104				
Comment Code					
S2 : Repair the levee slope damaged by foot traffic and prevent access where possible.					
Inspector Comment					
Slope damage caused by foot traffic.

Looking northeast at the landside slope.

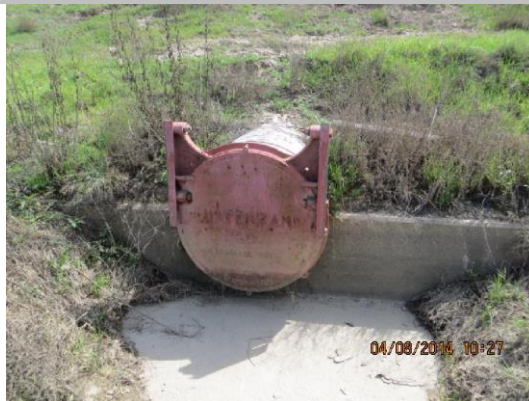
Photo 2 of 3 : UCIP\_SP\_2018\_39128\_60700.jpg

LM Start	3.13	Rating **	M	Issue No.	1200 (cont)	
LM End	3.13	Issue Type +	Ma	Location *		
Category	Supplemental			GPS Latitude/Longitude		
				Start	End	
Item	DWR UCIP LMA Responsibility			37.321444 °	37.321444 °	
				-120.928764 °	-120.928764 °	
DWR ID						
Comment Code						
Inspector Comment						
FS_ID:39128						
DS_ID:19574						
EP_NO: N/A						
Repair Type: Non-Urgent						
Crossing Status: Found						
UCIP Comments: Some minor erosion around headwall on LS toe.						
FIELD_STRUCT_DESC: 36-inch corrugated metal gravity drainage pipe						
through the levee, 8 feet below the crown. Flap gate on the waterside						
(WS) end. Brass cap No. 100 bench mark (BM) on the headwall on the						
landside (LS). [Additional Reference(s): DWR Levee Log, 2002. USACE						
San Joaquin O&M Manual 601.1, 1967, (HLM 3.16)].						
FS Date: 4/8/2014

Pipe, Flapgate, and headwall on WS toe.

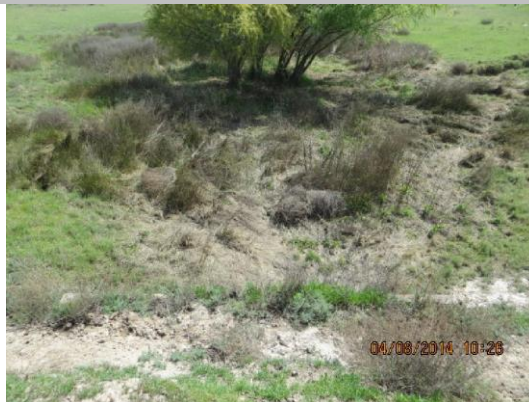
Photo 3 of 3 : UCIP\_SP\_2018\_39128\_60701.jpg

Pipe and headwall on LS toe.

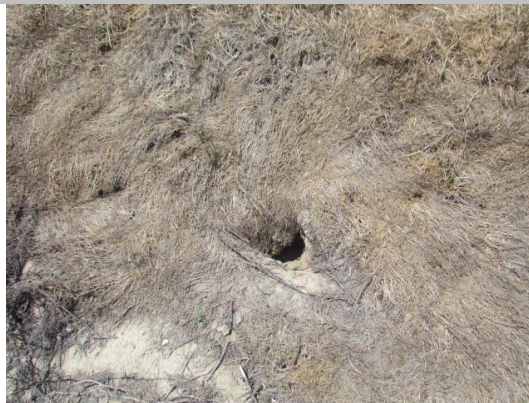
Photo 1 of 2 : SP\_2018\_NA0010\_118\_10\_20180307\_00008.jpg

LM Start	3.16	Rating **	M	Issue No.	10
LM End	3.16	Issue Type +	Ma	Location *	LS
Category	Earthen Levee			GPS Latitude/Longitude	
				Start	End
Item	Animal Control			37.321053 °	37.321053 °
				-120.928785 °	-120.928785 °
DWR ID	DWR_NA0010_01_s_2012_10				
Comment Code					
A3 : No rodents visible, but rodent burrows visible; need to backfill and compact or grout burrows.					
Inspector Comment					
Several rodent holes noted within this section. Rodent hole noted on waterside shoulder next to fence pole.

Looking at typical view of rodent holes on landward slope.

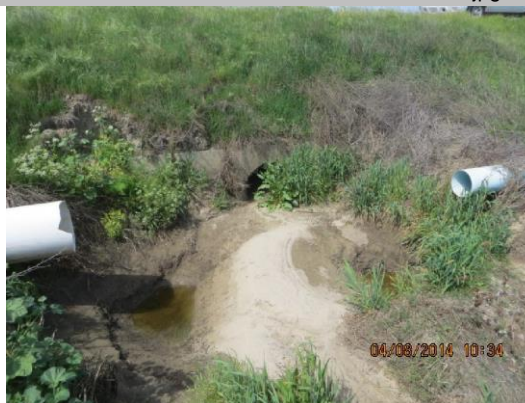
Photo 3 of 3 : UCIP\_SP\_2018\_50054\_60705.jpg

Comment Code						
Inspector Comment						
FS_ID:50054 DS_ID:19575 EP_NO: N/A Repair Type: Urgent Crossing Status: Found UCIP Comments: 7/19/2016 Same as previous inspection. Erosion present on LS slope. (DWR UCIP - omagana)4/08/2014 Pipe rusted through at Springline on LS toe. Flapgate blocked by sediment on WS toe. Heavy sediment on both ends of pipe. Need to contact owner to address issues. (DWR UCIP - omagana) FIELD_STRUCT_DESC: 36-inch corrugated metal gravity drainage pipe through the levee, 9.7 feet below the crown. Flap gate on the waterside (WS) end. Brass cap No. 100 bench mark (BM) on the headwall on the landside (LS). [Additional Reference(s): DWR Levee Log, 2002. USACE San Joaquin O&M Manual 601.1, 1967, (HLM 3.50)]. FS Date: 7/19/2016

Pipe and headwall on LS toe.

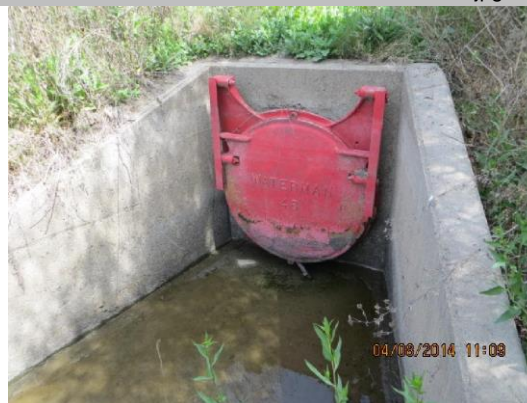
Photo 1 of 3 : UCIP\_SP\_2018\_39134\_60730.jpg

FS\_ID:39134  
DS\_ID:19607  
EP\_NO: N/A  
Repair Type: Non-Urgent  
Crossing Status: Found  
UCIP Comments: Pipe appears sleeved with a 12-inch steel pipe with a slide gate at the LS toe. No identified authorization for changes to this crossing. Need to contact owner to obtain additional information about the modifications to crossing.  
FIELD\_STRUCT\_DESC: 48-inch corrugated metal gravity drainage pipe through the levee, 14 feet below the crown. Flap gate on the waterside (WS) end. Brass cap No. 90 bench mark (BM) on the headwall on the landside (LS). [Additional Reference(s): DWR Levee Log, 2002. USACE San Joaquin O&M Manual 601.1, 1967, (HLM 4.16)].  
FS Date: 4/8/2014

Concrete headwall and 48-inch flapgate visible on WS toe.

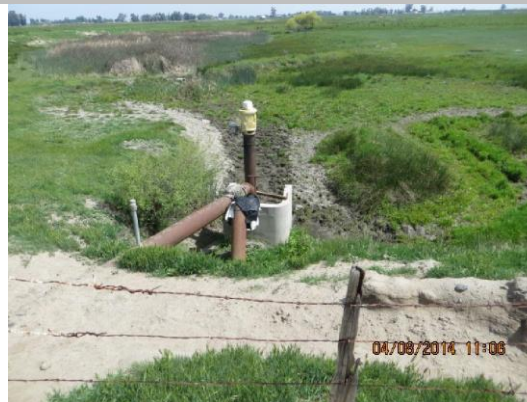
Photo 2 of 3 : UCIP\_SP\_2018\_39134\_60731.jpg

Assumed pipe exists under pump at LS toe.

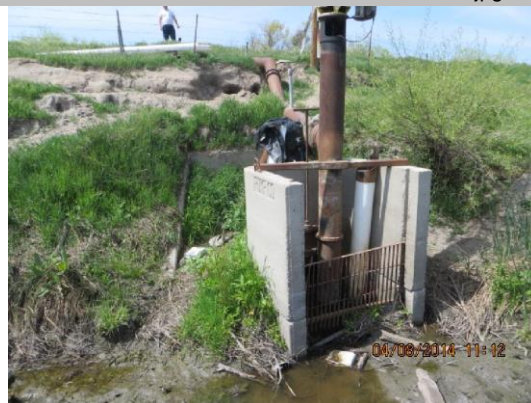
Photo 3 of 3 : UCIP\_SP\_2018\_39134\_60729.jpg

Comment Code						
Inspector Comment						
FS_ID:39134						
DS_ID:19607						
EP_NO: N/A						
Repair Type: Non-Urgent						
Crossing Status: Found						
UCIP Comments: Pipe appears sleeved with a 12-inch steel pipe with a slide gate at the LS toe. No identified authorization for changes to this crossing. Need to contact owner to obtain additional information about the modifications to crossing.						
FIELD_STRUCT_DESC: 48-inch corrugated metal gravity drainage pipe through the levee, 14 feet below the crown. Flap gate on the waterside (WS) end. Brass cap No. 90 bench mark (BM) on the headwall on the landside (LS). [Additional Reference(s): DWR Levee Log, 2002. USACE San Joaquin O&M Manual 601.1, 1967, (HLM 4.16)].						
FS Date: 4/8/2014

Concrete inlet, slidegate, and concrete headwall at LS toe.

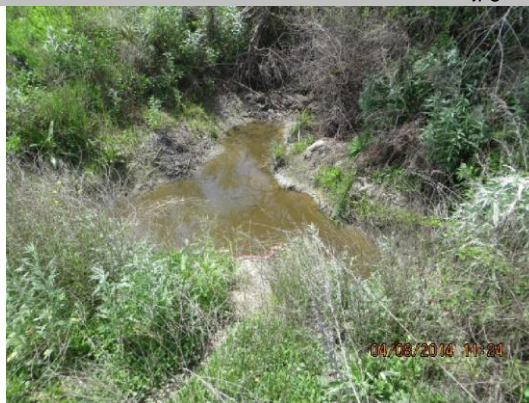
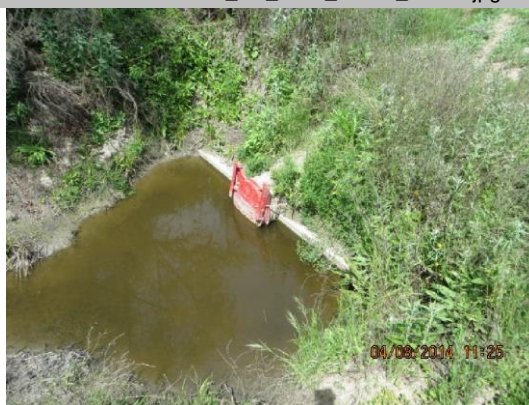
FS\_ID:39140  
DS\_ID:19608  
EP\_NO: N/A  
Repair Type: Non-Urgent  
Crossing Status: Found  
UCIP Comments: Dense vegetation and fence limits the inspector's visibility to identify signs of pipe failure (leaks) along the landward side. Recommend obtaining access to landward toe and removing vegetation along pipe alignment to conduct proper inspection of structure and appurtenances.  
FIELD\_STRUCT\_DESC: 24-inch corrugated metal gravity drainage pipe through the levee, 11.9 feet below the crown. Flap gate on the waterside (WS) end. Brass cap No. 90 bench mark (BM) on the headwall on the landside (LS). [Additional Reference(s): DWR Levee Log, 2002. USACE San Joaquin O&M Manual 601.1, 1967, (HLM 4.27)].  
FS Date: 4/8/2014

Pipe, flapgate, and headwall visible at WS toe.

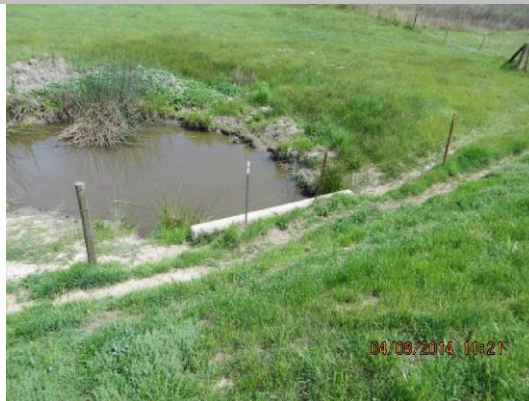
Photo 3 of 3 : UCIP\_SP\_2018\_39140\_60734.jpg

Concrete headwall at LS toe.

FS\_ID:39140  
 DS\_ID:19608  
 EP\_NO: N/A  
 Repair Type: Non-Urgent  
 Crossing Status: Found  
 UCIP Comments: Dense vegetation and fence limits the inspector's visibility to identify signs of pipe failure (leaks) along the landward side. Recommend obtaining access to landward toe and removing vegetation along pipe alignment to conduct proper inspection of structure and appurtenances.  
 FIELD\_STRUCT\_DESC: 24-inch corrugated metal gravity drainage pipe through the levee, 11.9 feet below the crown. Flap gate on the waterside (WS) end. Brass cap No. 90 bench mark (BM) on the headwall on the landside (LS). [Additional Reference(s): DWR Levee Log, 2002. USACE San Joaquin O&M Manual 601.1, 1967, (HLM 4.27)].  
 FS Date: 4/8/2014

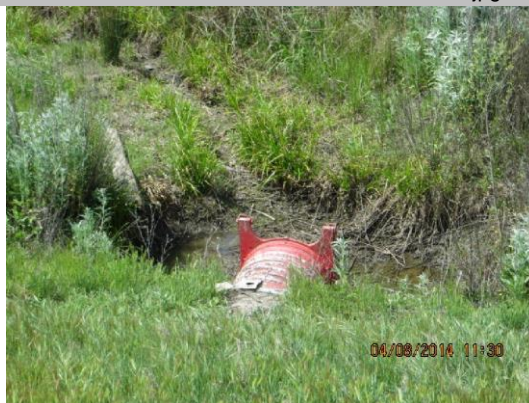
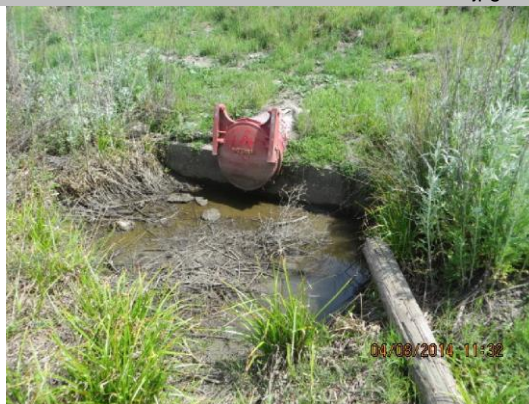
FS\_ID:39141  
DS\_ID:19609  
EP\_NO: N/A  
Repair Type: Non-Urgent  
Crossing Status: Found  
UCIP Comments: Dense vegetation limits the inspector's visibility to identify signs of pipe failure (leaks) along the waterward side. Recommend removing vegetation along pipe alignment to conduct proper inspection of structure and appurtenances.  
FIELD\_STRUCT\_DESC: 24-inch corrugated metal gravity drainage pipe through the levee, 10 feet below the crown. Flap gate on the waterside (WS) end. Brass cap No. 90 bench mark (BM) on the headwall on the landside (LS). [Additional Reference(s): DWR Levee Log, 2002. USACE San Joaquin O&M Manual 601.1, 1967, (HLM 4.72)].  
FS Date: 4/8/2014

Pipe, flapgate, and headwall on WS toe.

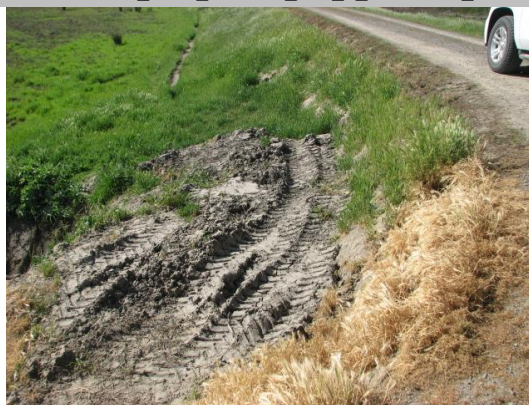
Photo 1 of 3 : SP\_2018\_NA0010\_118\_9\_20180420\_00271.jpg

LM Start	4.69	Rating **	A/W	Issue No.	9
LM End	4.69	Issue Type +	Ma	Location *	LS
Category	Earthen Levee			GPS Latitude/Longitude	
				Start	End
Item	Erosion / Bank Caving			37.302398 °	37.302398 °
				-120.920920 °	-120.920920 °
DWR ID	DWR_NA0010_01_s_2013_9				
Comment Code					
Inspector Comment					
Levee landside toe damaged by livestock.

Looking south at fill poorly placed on landward slope and toe. (Spring 2018)

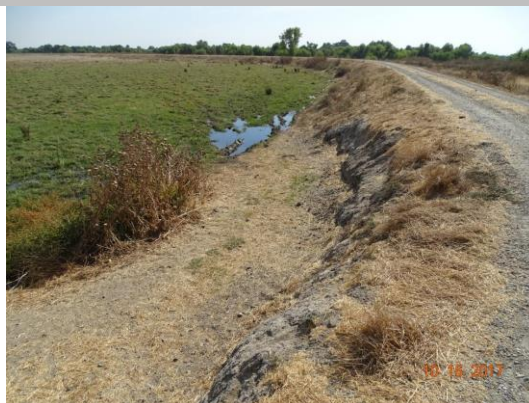
Photo 2 of 3 : SP\_2018\_NA0010\_118\_9\_20180307\_00006.jpg

Looking south at landside.

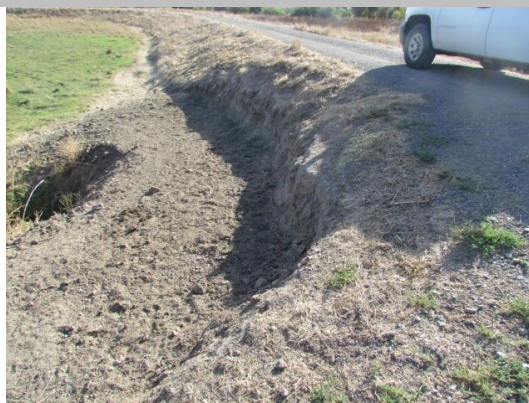
Photo 3 of 3 : SP\_2018\_NA0010\_118\_9\_20180307\_00007.jpg

LM Start	4.69	Rating **	A/W	Issue No.	9 (cont)	
LM End	4.69	Issue Type +	Ma	Location *	LS	
Category	Earthen Levee			GPS Latitude/Longitude		
				Start		End
Item	Erosion / Bank Caving			37.302398 °		37.302398 °
				-120.920920 °		-120.920920 °
DWR ID	DWR_NA0010_01_s_2013_9					
Comment Code						
Inspector Comment						
Levee landside toe damaged by livestock.

Looking at landward slope damaged by livestock.

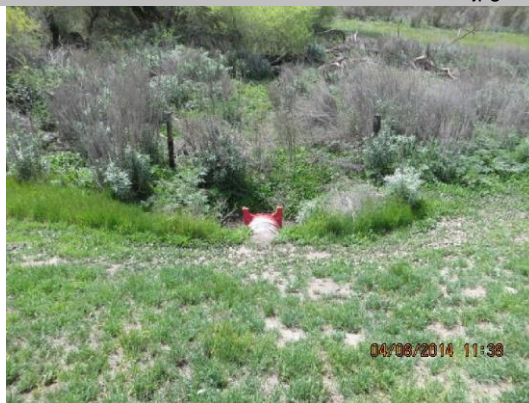
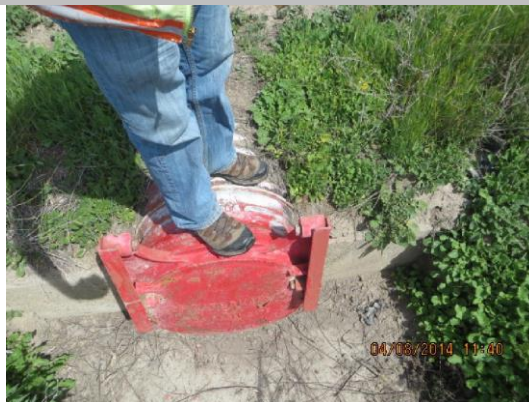
LM Start	5.02	Rating **	M	Issue No.	1208	
LM End	5.02	Issue Type +	Ma	Location *		
Category	Supplemental			GPS Latitude/Longitude		
				Start	End	
Item	DWR UCIP LMA Responsibility			37.298917 °	37.298917 °	
				-120.917262 °	-120.917262 °	
DWR ID						
Comment Code						
Inspector Comment						
FS_ID:39143 DS_ID:19610 EP_NO: N/A Repair Type: Non-Urgent Crossing Status: Found UCIP Comments: Non-functional -- sediment buildup against flapgate and inlet buried at landward side. FIELD_STRUCT_DESC: 24-inch corrugated metal gravity drainage pipe through the levee, 8 feet below the crown. Flap gate on the waterside (WS) end. Brass cap No. 90 bench mark (BM) on the headwall on the landside (LS). [Additional Reference(s): DWR Levee Log, 2002. USACE San Joaquin O&M Manual 601.1, 1967, (HLM 5.05)]. FS Date: 4/8/2014

Flapgate and headwall visible at WS toe.

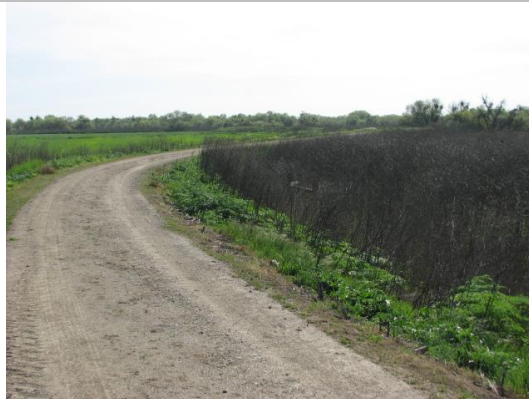
Photo 1 of 1 : SP\_2018\_NA0010\_118\_107\_20180420\_00272.jpg

LM Start	5.74	Rating **	U	Issue No.	107
LM End	6.20	Issue Type +	Ma	Location *	WS
Category	Earthen Levee			GPS Latitude/Longitude	
				Start	End
Item	Vegetation			37.304179 °	37.304911 °
				-120.906860 °	-120.899002 °
DWR ID	DWR_NA0010_01_f_2017_107				
Comment Code					
V2 : Remove the wild growth other than native grasses from the levee slopes.					
Inspector Comment

Looking south at dense veg on waterward slope. (Spring 2018)

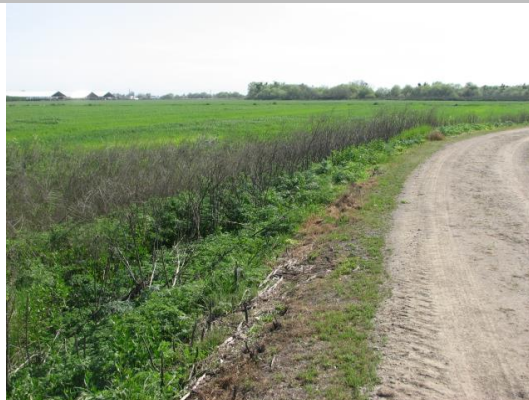
Photo 1 of 1 : SP\_2018\_NA0010\_118\_106\_20180420\_00273.jpg

LM Start	5.74	Rating **	U	Issue No.	106
LM End	6.20	Issue Type +	Ma	Location *	LS
Category	Earthen Levee			GPS Latitude/Longitude	
				Start	End
Item	Vegetation			37.304180 °	37.304911 °
				-120.906860 °	-120.899001 °
DWR ID	DWR_NA0010_01_f_2017_106				
Comment Code					
V2 : Remove the wild growth other than native grasses from the levee slopes.					
Inspector Comment

Looking south at dense veg on landward slope. (Spring 2018)

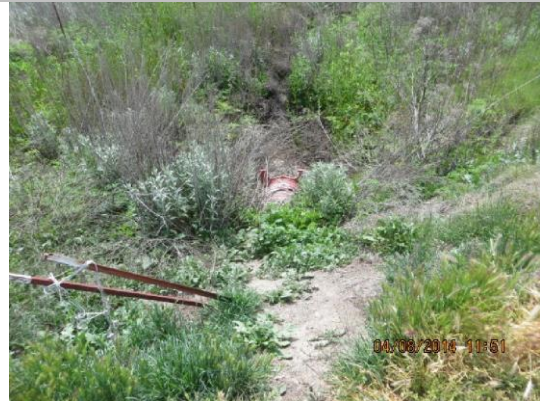
Photo 1 of 2 : UCIP\_SP\_2018\_39151\_60742.jpg

FS\_ID:39151  
DS\_ID:19611  
EP\_NO: N/A  
Repair Type: Non-Urgent  
Crossing Status: Found  
UCIP Comments: Dense vegetation limits the inspector's visibility to identify signs of pipe failure (leaks) along waterward and landward slopes. Recommend removing vegetation along pipe alignment to conduct proper inspection of structure and appurtenances. Landward side filled in with soil. Need to contact owner. If crossing is no longer used need to coordinate with CVFPB for proper abandonment.  
FIELD\_STRUCT\_DESC: 24-inch corrugated metal gravity drainage pipe through the levee, 8.6 feet below the crown. Flap gate on the waterside (WS) end. Brass cap No. 90 bench mark (BM) on the headwall on the landside (LS). [Additional Reference(s): DWR Levee Log, 2002. USACE San Joaquin O&M Manual 601.1, 1967, (HLM 5.95)].  
FS Date: 4/8/2014

Pipe, concrete headwall, and flapgate visible on WS toe.

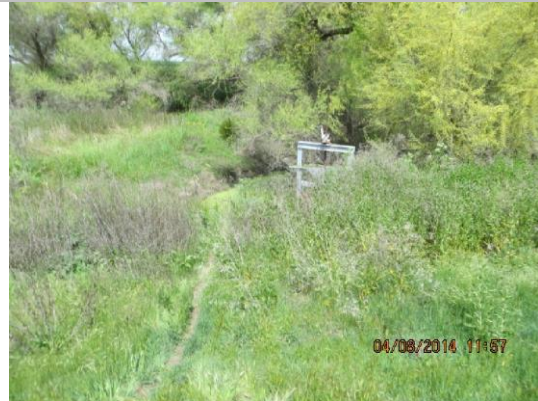
Photo 1 of 3 : UCIP\_SP\_2018\_39152\_60745.jpg

FS\_ID:39152  
DS\_ID:19612  
EP\_NO: N/A  
Repair Type: Non-Urgent  
Crossing Status: Found  
UCIP Comments: Dense vegetation limits the inspector's visibility to identify signs of pipe failure (leaks) along waterward and landward slopes. Recommend removing vegetation along pipe alignment to conduct proper inspection of structure and appurtenances. Pipe completely blocked by soil on LS toe due to animal activity. Slide gate blocked open.  
FIELD\_STRUCT\_DESC: 48-inch corrugated metal gravity drainage pipe through the levee, 13.1 feet below the crown. Walkway to slide gate at the concrete headwall on the landside (LS) toe. Flap gate at the concrete headwall on the waterside (WS) toe. Brass cap No. 90 bench mark (BM) on the headwall on the LS. Pipe crosses the levee at an angle. [Additional Reference(s): DWR Levee Log, 2002. USACE San Joaquin O&M Manual 601.1, 1967, (HLM 6.13)].  
FS Date: 4/8/2014

Slidegate at LS toe.

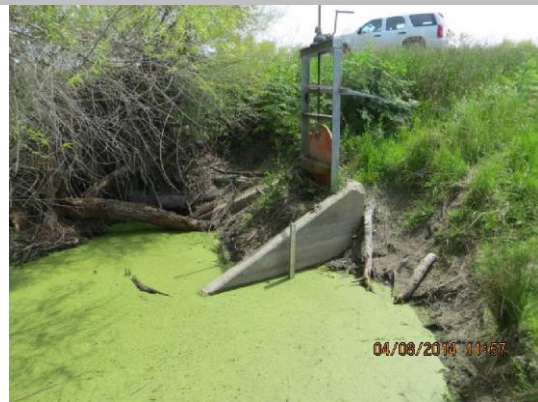
Photo 2 of 3 : UCIP\_SP\_2018\_39152\_60744.jpg

Pipe, concrete headwall, slidegate, and metal walkway on LS toe.

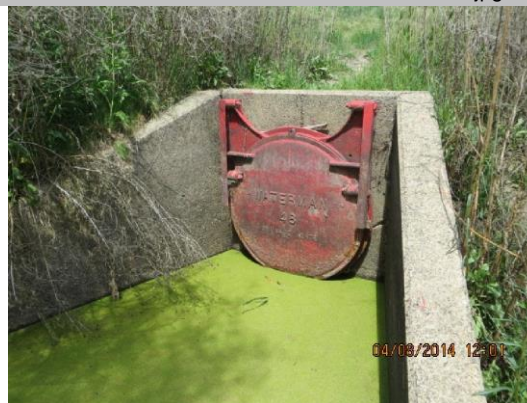
Photo 3 of 3 : UCIP\_SP\_2018\_39152\_60743.jpg

UCIP Comments: Dense vegetation limits the inspector's visibility to identify signs of pipe failure (leaks) along waterward and landward slopes. Recommend removing vegetation along pipe alignment to conduct proper inspection of structure and appurtenances. Pipe completely blocked by soil on LS toe due to animal activity. Slide gate blocked open.

Flapgate on concrete headwall at WS toe.

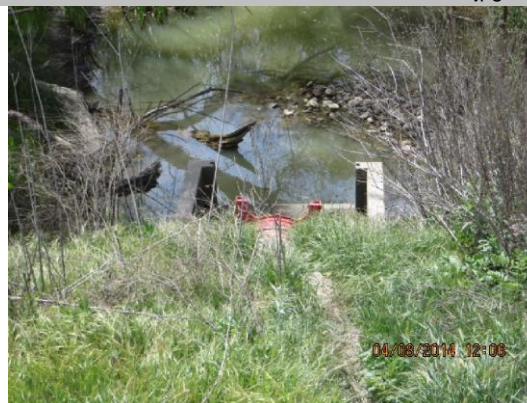
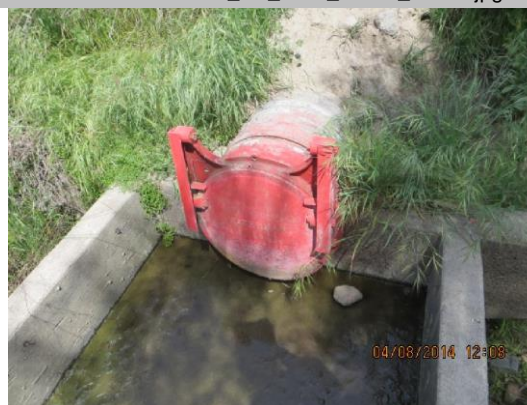
FS\_ID:39154  
DS\_ID:19613  
EP\_NO: N/A  
Repair Type: Non-Urgent  
Crossing Status: Found  
UCIP Comments: Dense vegetation limits the inspector's visibility to identify signs of pipe failure (leaks) along the slope. Recommend removing vegetation along pipe alignment to conduct proper inspection of structure and appurtenances.  
FIELD\_STRUCT\_DESC: 24-inch corrugated metal gravity drainage pipe through the levee, 9.5 feet below the crown. Flap gate on the waterside (WS) end. Slide gate on the landside (LS) end next to a 48-inch concrete riser with walkway over the top. Brass cap No. 90 bench mark (BM) on the headwall on the LS. [Additional Reference(s): DWR Levee Log, 2002. USACE San Joaquin O&M Manual 601.1, 1967, (HLM 6.40)].  
FS Date: 4/8/2014

Pipe, flapgate, and concrete headwall on WS toe.

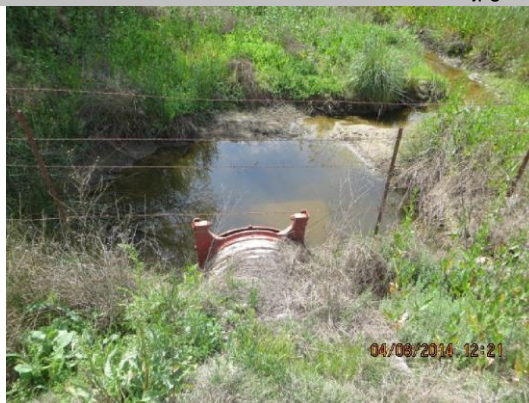
Photo 1 of 3 : UCIP\_SP\_2018\_50077\_60768.jpg

FS\_ID:50077  
DS\_ID:19615  
EP\_NO: N/A  
Repair Type: Non-Urgent  
Crossing Status: Found  
UCIP Comments: 7/19/2016 Potential LS slope damage--difficult to determine due to dense vegetation. Limited access on WS toe due to wire fence. (DWR UCIP - omagana)4/08/2014 Slide gate blocked by debris at LS toe. Flapgate won't close because of debris. Dense vegetation limits the inspector's visibility to identify signs of pipe failure (leaks) along the slope. Recommend removing vegetation along pipe alignment to conduct proper inspection of structure and appurtenances. (DWR UCIP - omagana)  
FIELD\_STRUCT\_DESC: 36-inch corrugated metal gravity drainage pipe through the levee, 10.3 feet below the crown. Slide gate on the landside (LS) toe. Flap gate on the waterside (WS) end. Brass cap No. 90 bench mark (BM) on the headwall on the LS. [Additional Reference(s): DWR Levee Log, 2002. USACE San Joaquin O&M Manual 601.1, 1967, (HLM 6.90)].

Pipe, headwall, and flapgate on WS toe.

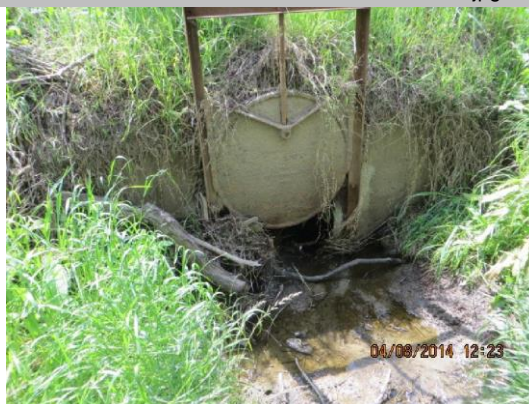
Photo 2 of 3 : UCIP\_SP\_2018\_50077\_60767.jpg

Pipe, concrete headwall, and slidegate on LS toe. Debris blocking closure of slidegate.

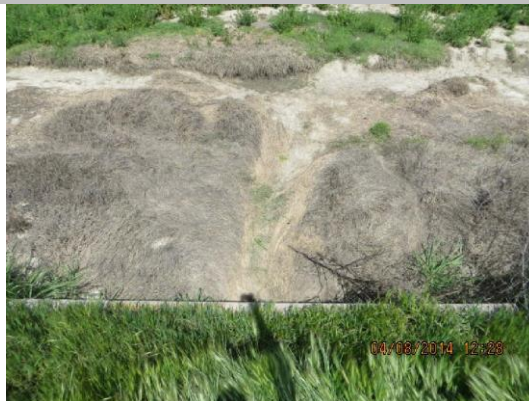
Photo 3 of 3 : UCIP\_SP\_2018\_42851\_60771.jpg

Comment Code						
Inspector Comment						
FS_ID:42851						
DS_ID:19616						
EP_NO: N/A						
Repair Type: Non-Urgent						
Crossing Status: Found						
UCIP Comments: Pipe failing and corroded through at LS toe. Need to contact owner to determine status of crossing. Also dense vegetation limits the inspector's visibility to identify signs of pipe failure (leaks) along the landward slope. Recommend removing vegetation along pipe alignment to conduct proper inspection of structure.						
FIELD_STRUCT_DESC: 24-inch corrugated metal gravity drainage pipe through the levee, 5.1 feet below the crown. Flap gate on the waterside (WS) end. Brass cap No. 90 bench mark (BM) on the headwall on the landside (LS). [Additional Reference(s): DWR Levee Log, 2002. USACE San Joaquin O&M Manual 601.1, 1967, (HLM 7.21)].						
FS Date: 4/8/2014

Pipe and Concrete headwall visible on LS toe.
