**Flood Control Project Maintenance  
Levee Inspections**

## Maintenance Issue Types Only, Levee Inspection Report By Mile - Spring 2018

### Lower San Joaquin Levee District

Waterway	Bank	Unit Miles	Inspection Start/End	Inspector
Unit No. 01 San Joaquin River	Right	22.52	04/04/2018 04/16/2018	Richard Willoughby

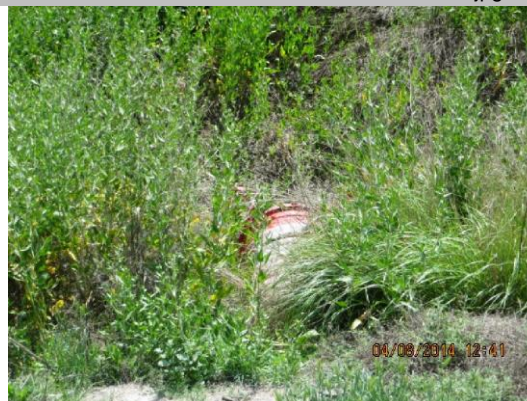
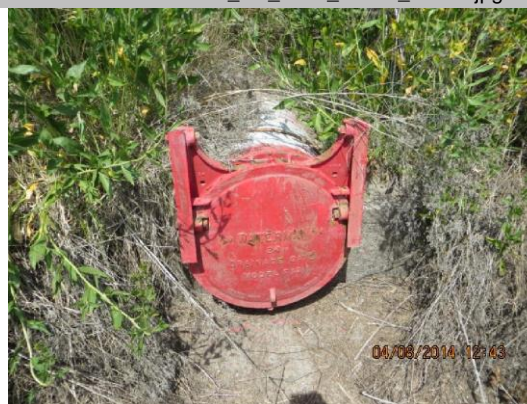
FS\_ID:39161  
DS\_ID:19618  
EP\_NO: N/A  
Repair Type: Non-Urgent  
Crossing Status: Found  
UCIP Comments: Dense vegetation limits the inspector's visibility to identify signs of pipe failure (leaks) along the slope. Recommend removing vegetation along pipe alignment to conduct proper inspection of structure and appurtenances.  
FIELD\_STRUCT\_DESC: 24-inch corrugated metal gravity drainage pipe through the levee, 8 feet below the crown. Flap gate on the waterside (WS) end. Brass cap No. 80 bench mark (BM) on the headwall on the landside (LS). [Additional Reference(s): DWR Levee Log, 2002. USACE San Joaquin O&M Manual 601.1, 1967, (HLM 7.46)].  
FS Date: 4/8/2014

Pipe and flapgate visible on WS toe.

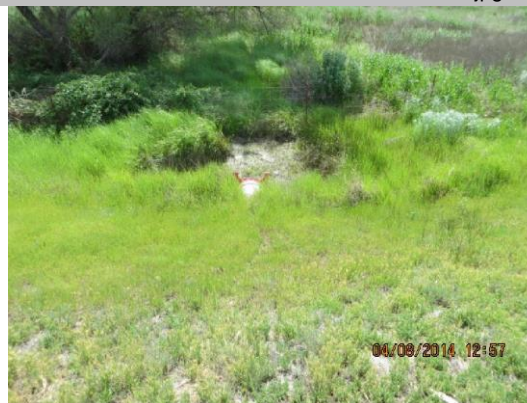
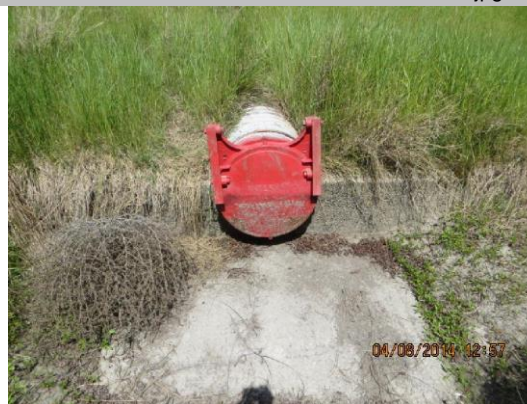
FS\_ID:39244  
DS\_ID:19620  
EP\_NO: N/A  
Repair Type: Non-Urgent  
Crossing Status: Found  
UCIP Comments: Dense vegetation limits the inspector's visibility to identify signs of pipe failure (leaks) along the slope. Recommend removing vegetation along pipe alignment to conduct proper inspection of structure.  
FIELD\_STRUCT\_DESC: 24-inch corrugated metal gravity drainage pipe through the levee, 8 feet below the crown. Flap gate on the waterside (WS) end. Brass cap No. 80 bench mark (BM) on the headwall on the landside (LS). [Additional Reference(s): DWR Levee Log, 2002. USACE San Joaquin O&M Manual 601.1, 1967, (HLM 8.07)].  
FS Date: 4/9/2014

Pipe, Headwall, and flapgate at WS toe.

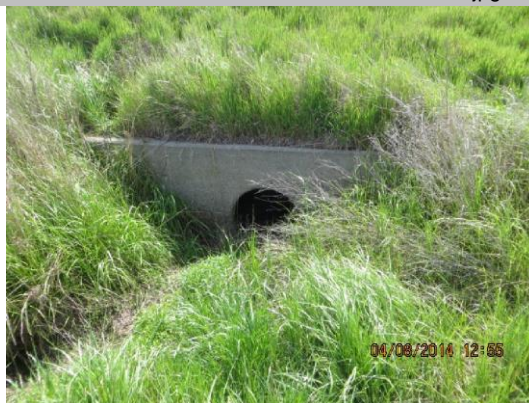
Photo 3 of 3 : UCIP\_SP\_2018\_39244\_60846.jpg

Comment Code						
Inspector Comment						
FS_ID:39244 DS_ID:19620 EP_NO: N/A Repair Type: Non-Urgent Crossing Status: Found UCIP Comments: Dense vegetation limits the inspector's visibility to identify signs of pipe failure (leaks) along the slope. Recommend removing vegetation along pipe alignment to conduct proper inspection of structure. FIELD_STRUCT_DESC: 24-inch corrugated metal gravity drainage pipe through the levee, 8 feet below the crown. Flap gate on the waterside (WS) end. Brass cap No. 80 bench mark (BM) on the headwall on the landside (LS). [Additional Reference(s): DWR Levee Log, 2002. USACE San Joaquin O&M Manual 601.1, 1967, (HLM 8.07)]. FS Date: 4/9/2014

Pipe and concrete headwall on LS toe.

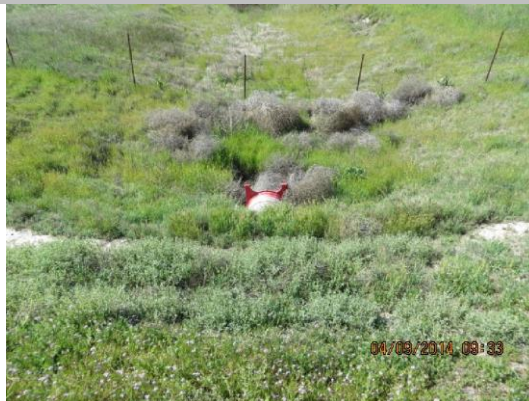
Photo 1 of 3 : UCIP\_SP\_2018\_39245\_60850.jpg

Concrete headwall, pipe, and flapgate at WS toe.

Comment Code						
Inspector Comment						
FS_ID:39245 DS_ID:19621 EP_NO: N/A Repair Type: Non-Urgent Crossing Status: Found UCIP Comments: Dense vegetation limits the inspector's visibility to identify signs of pipe failure (leaks) along the slope. Recommend removing vegetation along pipe alignment to conduct proper inspection of structure. Sediment buildup at landward toe. FIELD_STRUCT_DESC: 24-inch corrugated metal gravity drainage pipe through the levee, 9.5 feet below the crown. Flap gate on the waterside (WS) end. Brass cap No. 80 bench mark (BM) on the headwall on the landside (LS). [Additional Reference(s): DWR Levee Log, 2002. USACE San Joaquin O&M Manual 601.1, 1967, (HLM 8.41)]. FS Date: 4/9/2014

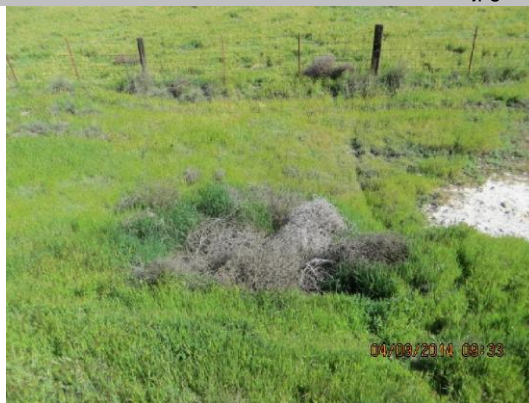
Photo 3 of 3 : UCIP\_SP\_2018\_39245\_60849.jpg

Pipe and concrete headwall at LS toe. Note heavy vegetation.

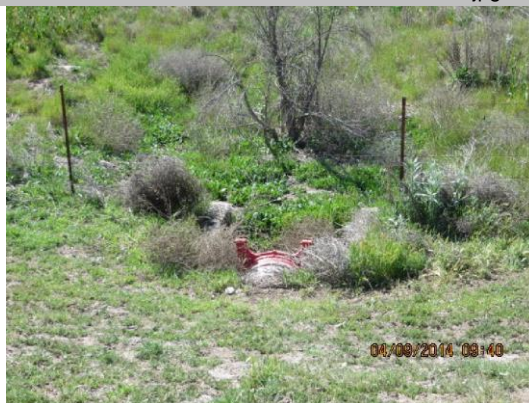
Photo 1 of 3 : UCIP\_SP\_2018\_39246\_60854.jpg

LM Start	8.57	Rating **	A/W	Issue No.	1220
LM End	8.57	Issue Type +	Ma	Location *	
Category	Supplemental			GPS Latitude/Longitude	
				Start	End
Item	DWR UCIP LMA Responsibility			37.296552 °	37.296552 °
				-120.858596 °	-120.858596 °
DWR ID					
Comment Code					
Inspector Comment					
FS_ID:39246					
DS_ID:19622					
EP_NO: N/A					
Repair Type: No Action Needed					
Crossing Status: Found					
UCIP Comments:					
FIELD_STRUCT_DESC: 24-inch corrugated metal gravity drainage pipe					
through the levee, 9 feet below the crown. Flap gate on the waterside					
(WS) end. Brass cap No. 80 bench mark (BM) on the headwall on the					
landside (LS). [Additional Reference(s): DWR Levee Log, 2002. USACE					
San Joaquin O&M Manual 601.1, 1967, (HLM 8.61)].					
FS Date: 4/9/2014

Pipe, Flapgate, and headwall on WS toe.

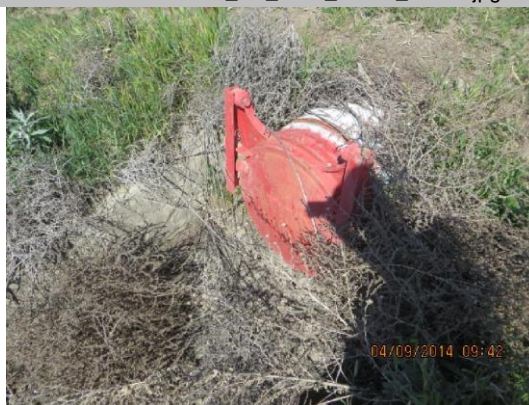
Photo 2 of 3 : UCIP\_SP\_2018\_39246\_60855.jpg

Pipe, Flapgate, and headwall on WS toe.

LM Start	8.57	Rating **	A/W	Issue No.	1220 (cont)	
LM End	8.57	Issue Type +	Ma	Location *		
Category	Supplemental			GPS Latitude/Longitude		
				Start	End	
Item	DWR UCIP LMA Responsibility			37.296552 °	37.296552 °	
				-120.858596 °	-120.858596 °	
DWR ID						
Comment Code						
Inspector Comment						
FS_ID:39246						
DS_ID:19622						
EP_NO: N/A						
Repair Type: No Action Needed						
Crossing Status: Found						
UCIP Comments:						
FIELD_STRUCT_DESC: 24-inch corrugated metal gravity drainage pipe						
through the levee, 9 feet below the crown. Flap gate on the waterside						
(WS) end. Brass cap No. 80 bench mark (BM) on the headwall on the						
landside (LS). [Additional Reference(s): DWR Levee Log, 2002. USACE						
San Joaquin O&M Manual 601.1, 1967, (HLM 8.61)].						
FS Date: 4/9/2014

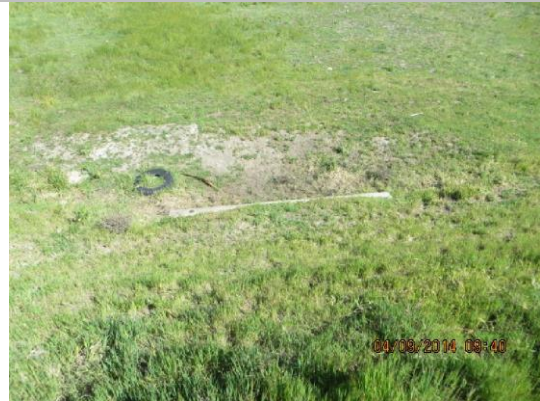
Photo 3 of 3 : UCIP\_SP\_2018\_39246\_60853.jpg

Pipe and headwall at LS toe.

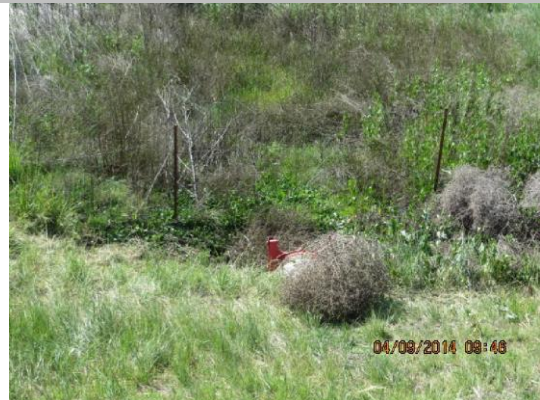
Photo 1 of 3 : UCIP\_SP\_2018\_39247\_60859.jpg

Comment Code					
Inspector Comment					
FS_ID:39247					
DS_ID:19623					
EP_NO: N/A					
Repair Type: Non-Urgent					
Crossing Status: Found					
UCIP Comments: Dense vegetation limits the inspector's visibility to identify signs of pipe failure (leaks) along the slope. Recommend removing vegetation along pipe alignment to conduct proper inspection of structure.					
FIELD_STRUCT_DESC: 24-inch corrugated metal gravity drainage pipe through the levee, 9.1 feet below the crown. Flap gate on the waterside (WS) end. Brass cap No. 80 bench mark (BM) on the headwall on the landside (LS). [Additional Reference(s): DWR Levee Log, 2002. USACE San Joaquin O&M Manual 601.1, 1967, (HLM 8.93)].					
FS Date: 4/9/2014

Pipe, flapgate, and headwall on WS toe.

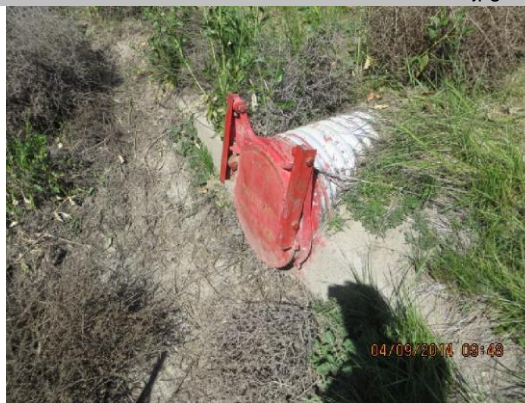
Photo 2 of 3 : UCIP\_SP\_2018\_39247\_60860.jpg

FS\_ID:39247  
DS\_ID:19623  
EP\_NO: N/A  
Repair Type: Non-Urgent  
Crossing Status: Found  
UCIP Comments: Dense vegetation limits the inspector's visibility to identify signs of pipe failure (leaks) along the slope. Recommend removing vegetation along pipe alignment to conduct proper inspection of structure.  
FIELD\_STRUCT\_DESC: 24-inch corrugated metal gravity drainage pipe through the levee, 9.1 feet below the crown. Flap gate on the waterside (WS) end. Brass cap No. 80 bench mark (BM) on the headwall on the landside (LS). [Additional Reference(s): DWR Levee Log, 2002. USACE San Joaquin O&M Manual 601.1, 1967, (HLM 8.93)].  
FS Date: 4/9/2014

Pipe, flapgate, and headwall on WS toe.

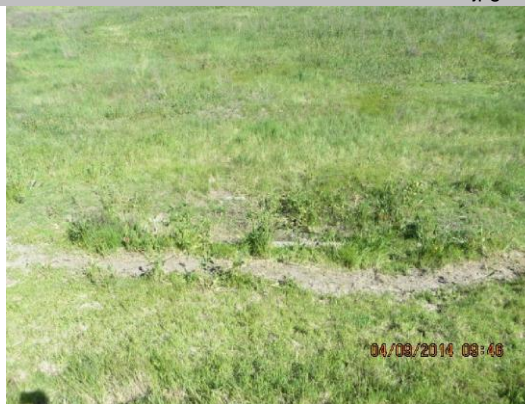
Photo 3 of 3 : UCIP\_SP\_2018\_39247\_60858.jpg

Pipe and headwall visible on LS toe.

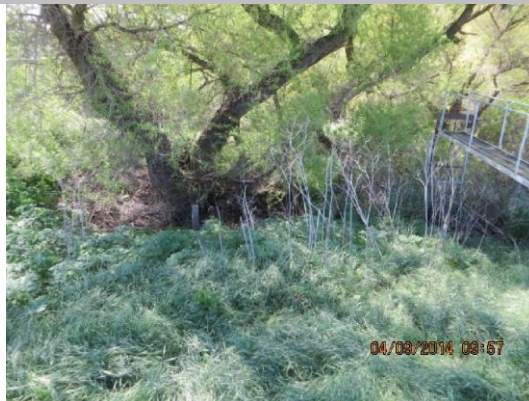
Photo 1 of 3 : UCIP\_SP\_2018\_39249\_60870.jpg

FS\_ID:39249  
DS\_ID:19625  
EP\_NO: N/A  
Repair Type: Non-Urgent  
Crossing Status: Found  
UCIP Comments: Dense vegetation limits the inspector's visibility to identify signs of pipe failure (leaks) along the slope. Recommend removing vegetation along pipe alignment to conduct proper inspection of structure. Some sediment buildup in pipe.  
FIELD\_STRUCT\_DESC: 36-inch corrugated metal gravity drainage pipe through the levee, 10 feet below the crown. Flap gate on the waterside (WS) end. Brass cap No. 80 bench mark (BM) on the headwall on the landside (LS). [Additional Reference(s): DWR Levee Log, 2002. USACE San Joaquin O&M Manual 601.1, 1967, (HLM 9.00)].  
FS Date: 4/9/2014

Pipe and flapgate visible on WS toe.

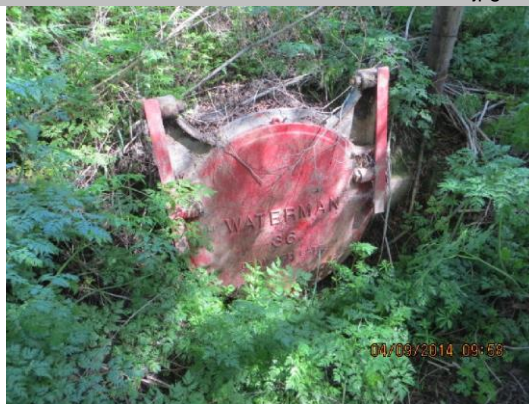
Photo 2 of 3 : UCIP\_SP\_2018\_39249\_60869.jpg

Pipe and flapgate visible on WS toe.

Comment Code						
Inspector Comment						
FS_ID:39249						
DS_ID:19625						
EP_NO: N/A						
Repair Type: Non-Urgent						
Crossing Status: Found						
UCIP Comments: Dense vegetation limits the inspector's visibility to identify signs of pipe failure (leaks) along the slope. Recommend removing vegetation along pipe alignment to conduct proper inspection of structure. Some sediment buildup in pipe.						
FIELD_STRUCT_DESC: 36-inch corrugated metal gravity drainage pipe through the levee, 10 feet below the crown. Flap gate on the waterside (WS) end. Brass cap No. 80 bench mark (BM) on the headwall on the landside (LS). [Additional Reference(s): DWR Levee Log, 2002. USACE San Joaquin O&M Manual 601.1, 1967, (HLM 9.00)].						
FS Date: 4/9/2014

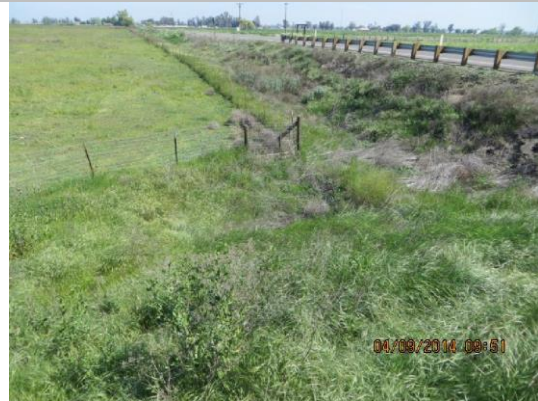
Photo 3 of 3 : UCIP\_SP\_2018\_39249\_60868.jpg

Pipe and headwall visible on LS toe.

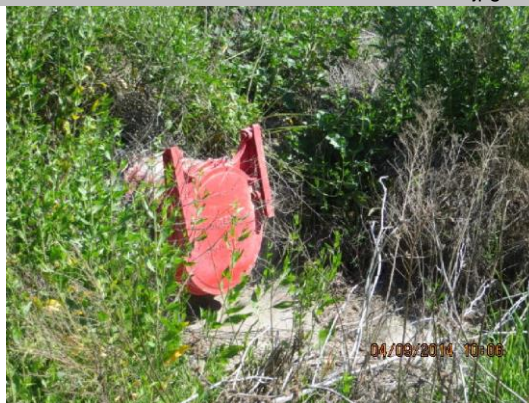
Photo 2 of 2 : UCIP\_SP\_2018\_39250\_60871.jpg

Comment Code						
Inspector Comment						
FS_ID:39250 DS_ID:19626 EP_NO: N/A Repair Type: Non-Urgent Crossing Status: Found UCIP Comments: Dense vegetation limits the inspector's visibility to identify signs of pipe failure (leaks) along the slope. Recommend removing vegetation along pipe alignment to conduct proper inspection of structure. FIELD_STRUCT_DESC: 24-inch corrugated metal gravity drainage pipe through the levee, 10 feet below the crown. Flap gate on the waterside (WS) end. Brass cap No. 80 bench mark (BM) on the headwall on the landside (LS). [Additional Reference(s): DWR Levee Log, 2002. USACE San Joaquin O&M Manual 601.1, 1967, (HLM 9.03)]. FS Date: 4/9/2014

Pipe, concrete headwall, and flapgate at WS toe.

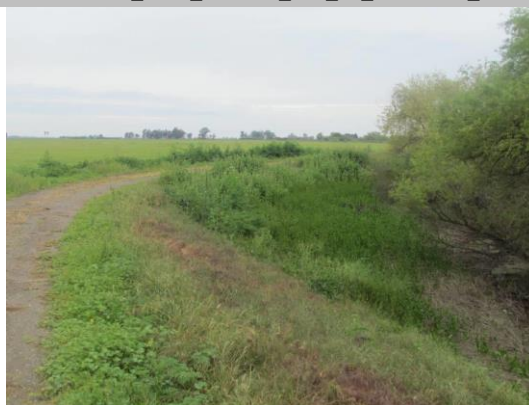
Photo 1 of 1 : SP\_2018\_NA0010\_118\_92\_20180307\_00017.jpg

LM Start	8.99	Rating **	U	Issue No.	92
LM End	9.43	Issue Type +	Ma	Location *	WS
Category	Earthen Levee			GPS Latitude/Longitude	
				Start	End
Item	Vegetation			37.297497 °	37.295310 °
				-120.851068 °	-120.843918 °
DWR ID	DWR_NA0010_01_s_2017_92				
Comment Code					
V2 : Remove the wild growth other than native grasses from the levee slopes.					
Inspector Comment

Looking southwest at dense veg on waterward slope.

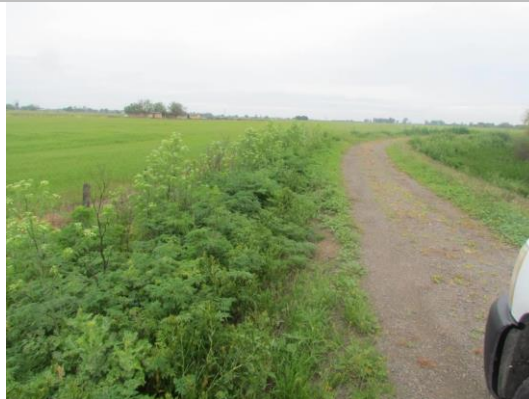
Photo 1 of 1 : SP\_2018\_NA0010\_118\_6\_20180307\_00004.jpg

LM Start	8.99	Rating **	U	Issue No.	6
LM End	9.61	Issue Type +	Ma	Location *	LS
Category	Earthen Levee			GPS Latitude/Longitude	
				Start	End
Item	Vegetation			37.297497°	37.295138°
				-120.851068°	-120.840857°
DWR ID	DWR_NA0010_01_s_2017_6				
Comment Code					
V2 : Remove the wild growth other than native grasses from the levee slopes.					
Inspector Comment

Looking south at dense veg on landward slope.

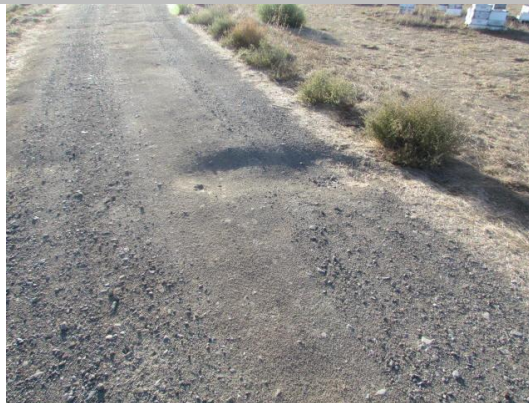
Photo 1 of 3 : SP\_2018\_NA0010\_118\_14\_20180307\_00010.jpg

LM Start	9.57	Rating **	A/W	Issue No.	14
LM End	9.57	Issue Type +	Ma	Location *	CR
Category	Earthen Levee			GPS Latitude/Longitude	
				Start	End
Item	Crown Surface / Depressions / Rutting			37.295517 °	37.295517 °
				-120.841452 °	-120.841452 °
DWR ID	DWR_NA0010_01_s_2015_14				
Comment Code					
C2 : Repair depressions or ruts in the crown or slope.					
Inspector Comment					
Depression greater than 3" deep by 18" wide by 18" long on levee crown

Looking at depression on levee crown. (Fall 2015)

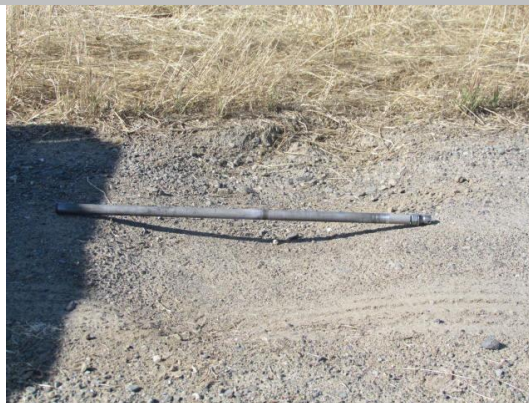
Photo 3 of 3 : SP\_2018\_NA0010\_118\_14\_20180307\_00012.jpg

Looking west at depression on levee crown.

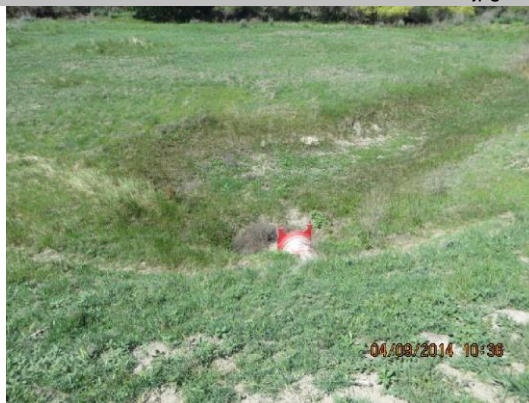
Photo 1 of 3 : UCIP\_SP\_2018\_39253\_60884.jpg

Comment Code						
Inspector Comment						
FS_ID:39253						
DS_ID:19629						
EP_NO: N/A						
Repair Type: Non-Urgent						
Crossing Status: Found						
UCIP Comments: Dense vegetation blocks waterward and landward toes Recommend removing vegetation from both toes. Also sediment buildup in pipe visible from landward side.						
FIELD_STRUCT_DESC: 24-inch corrugated metal gravity drainage pipe through the levee, 9 feet below the crown. Flap gate on the waterside (WS) end. Brass cap No. 69 bench mark (BM) on the headwall on the landside (LS). [Additional Reference(s): DWR Levee Log, 2002. USACE San Joaquin O&M Manual 601.1, 1967, (HLM 10.23)].						
FS Date: 4/9/2014

Pipe, headwall, and flapgate on WS toe.

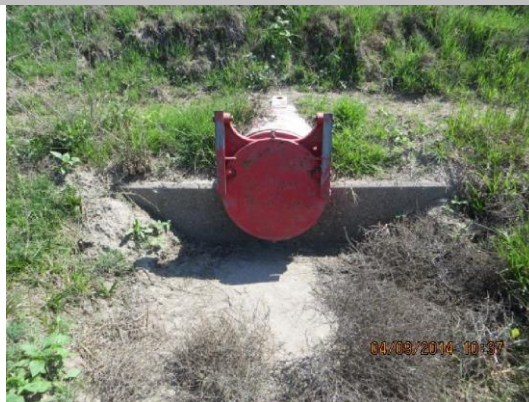
Photo 2 of 3 : UCIP\_SP\_2018\_39253\_60886.jpg

Pipe, headwall, and flapgate at WS toe.

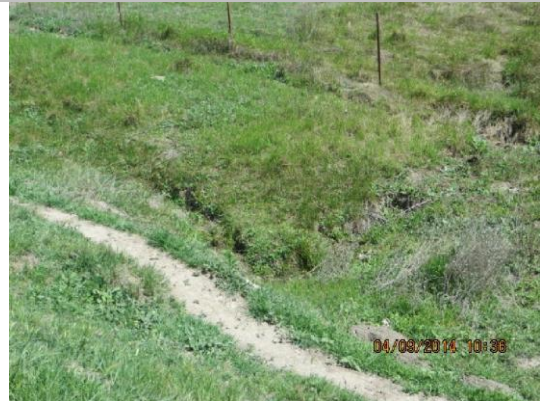
Photo 3 of 3 : UCIP\_SP\_2018\_39253\_60885.jpg

Item	DWR UCIP LMA Responsibility			37.287511 °	37.287511 °	
				-120.840251 °	-120.840251 °	
DWR ID						
Comment Code						
Inspector Comment						
FS_ID:39253 DS_ID:19629 EP_NO: N/A Repair Type: Non-Urgent Crossing Status: Found UCIP Comments: Dense vegetation blocks waterward and landward toes Recommend removing vegetation from both toes. Also sediment buildup in pipe visible from landward side. FIELD_STRUCT_DESC: 24-inch corrugated metal gravity drainage pipe through the levee, 9 feet below the crown. Flap gate on the waterside (WS) end. Brass cap No. 69 bench mark (BM) on the headwall on the landside (LS). [Additional Reference(s): DWR Levee Log, 2002. USACE San Joaquin O&M Manual 601.1, 1967, (HLM 10.23)]. FS Date: 4/9/2014

Pipe and headwall at LS toe.

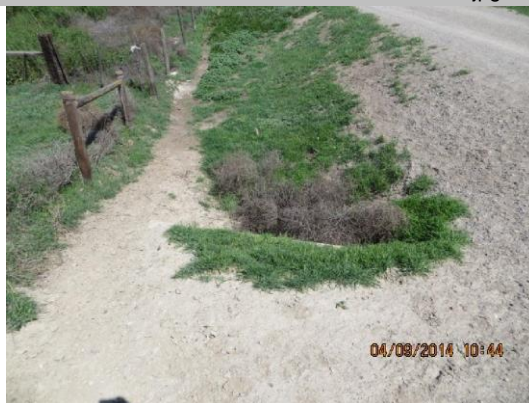
Photo 2 of 3 : UCIP\_SP\_2018\_33687\_60889.jpg

LM Start	10.68	Rating **	A/W	Issue No.	1228 (cont)
LM End	10.68	Issue Type +	Ma	Location *	
Category	Supplemental			GPS Latitude/Longitude	
				Start	End
Item	DWR UCIP LMA Responsibility			37.283740 °	37.283740 °
				-120.833452 °	-120.833452 °
DWR ID					
Comment Code					
Inspector Comment					
FS_ID:33687					
DS_ID:19630					
EP_NO: N/A					
Repair Type: No Action Needed					
Crossing Status: Found					
UCIP Comments:					
FIELD_STRUCT_DESC: 24-inch corrugated metal gravity drainage pipe through the levee, 7 feet below the crown. Flap gate on the waterside (WS) end. Brass cap No. 68 bench mark (BM) on the headwall on the landside (LS). [Additional Reference(s): DWR Levee Log, 2002. USACE San Joaquin O&M Manual 601.1, 1967, (HLM 10.72)].					
FS Date: 4/9/2014

Pipe and headwall on LS toe.

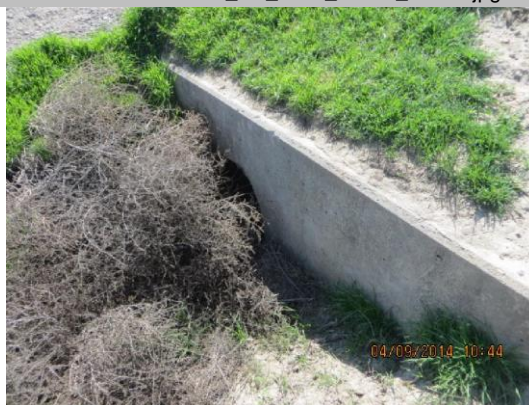
Photo 3 of 3 : UCIP\_SP\_2018\_33687\_60888.jpg

Pipe and headwall on LS toe.

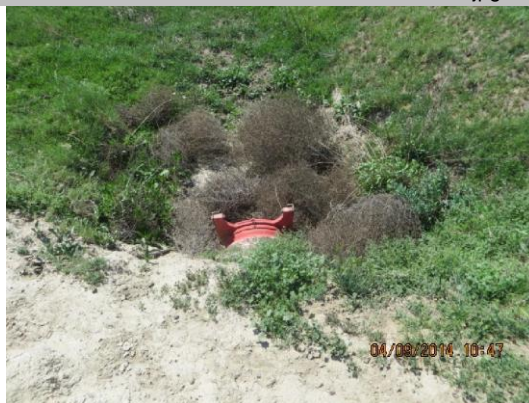
Photo 1 of 3 : UCIP\_SP\_2018\_39254\_60894.jpg

LM Start	10.69	Rating **	A/W	Issue No.	1229
LM End	10.69	Issue Type +	Ma	Location *	
Category	Supplemental			GPS Latitude/Longitude	
				Start	End
Item	DWR UCIP LMA Responsibility			37.283710 °	37.283710 °
				-120.833329 °	-120.833329 °
DWR ID					
Comment Code					
Inspector Comment					
FS_ID:39254					
DS_ID:19631					
EP_NO: N/A					
Repair Type: No Action Needed					
Crossing Status: Found					
UCIP Comments:					
FIELD_STRUCT_DESC: 24-inch corrugated metal gravity drainage pipe through the levee, 7 feet below the crown. Flap gate on the waterside (WS) end. Brass cap No. 67 bench mark (BM) on the headwall on the landside (LS). [Additional Reference(s): DWR Levee Log, 2002. USACE San Joaquin O&M Manual 601.1, 1967, (HLM 10.72)].					
FS Date: 4/9/2014

Headwall, pipe, and flapgate on WS toe.

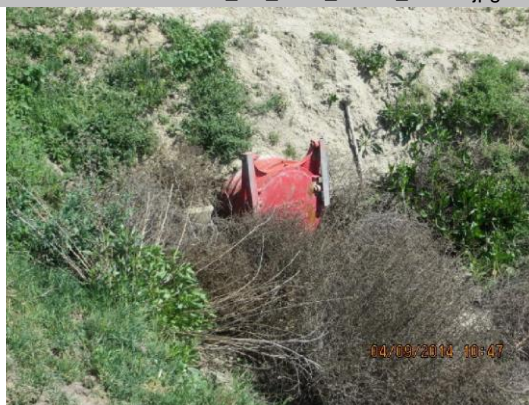
Photo 2 of 3 : UCIP\_SP\_2018\_39254\_60893.jpg

Headwall, pipe, and flapgate on WS toe.

LM Start	10.69	Rating **	A/W	Issue No.	1229 (cont)	
LM End	10.69	Issue Type +	Ma	Location *		
Category	Supplemental			GPS Latitude/Longitude		
				Start	End	
Item	DWR UCIP LMA Responsibility			37.283710 °	37.283710 °	
				-120.833329 °	-120.833329 °	
DWR ID						
Comment Code						
Inspector Comment						
FS_ID:39254						
DS_ID:19631						
EP_NO: N/A						
Repair Type: No Action Needed						
Crossing Status: Found						
UCIP Comments:						
FIELD_STRUCT_DESC: 24-inch corrugated metal gravity drainage pipe						
through the levee, 7 feet below the crown. Flap gate on the waterside						
(WS) end. Brass cap No. 67 bench mark (BM) on the headwall on the						
landside (LS). [Additional Reference(s): DWR Levee Log, 2002. USACE						
San Joaquin O&M Manual 601.1, 1967, (HLM 10.72)].						
FS Date: 4/9/2014

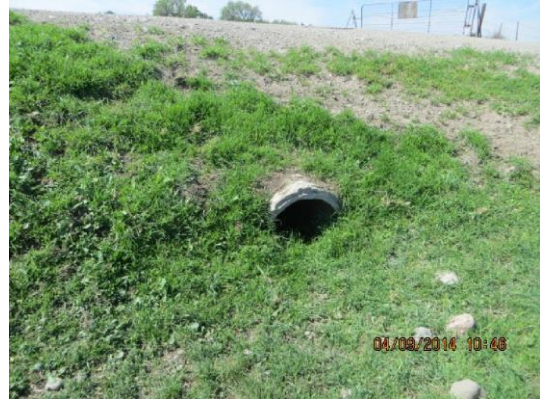
Photo 3 of 3 : UCIP\_SP\_2018\_39254\_60895.jpg

Concrete pipe visible on LS slope.

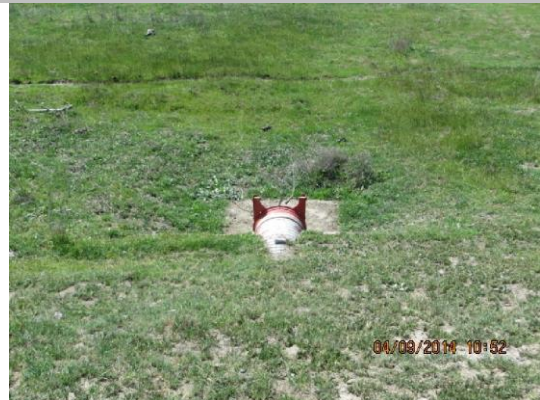
Photo 1 of 3 : UCIP\_SP\_2018\_39255\_60897.jpg

LM Start	10.98	Rating **	M	Issue No.	1230
LM End	10.98	Issue Type +	Ma	Location *	
Category	Supplemental			GPS Latitude/Longitude	
				Start	End
Item	DWR UCIP LMA Responsibility			37.282627 °	37.282627 °
				-120.828233 °	-120.828233 °
DWR ID					
Comment Code					
Inspector Comment					
FS_ID:39255					
DS_ID:19632					
EP_NO: N/A					
Repair Type: Non-Urgent					
Crossing Status: Found					
UCIP Comments: Dense vegetation blocks landward headwall.					
Recommend removing excess vegetation on landward toe.					
FIELD_STRUCT_DESC: 24-inch corrugated metal gravity drainage pipe					
through the levee, 6 feet below the crown. Flap gate on the waterside					
(WS) end. Brass cap No. 66 bench mark (BM) on the headwall on the					
landside (LS). [Additional Reference(s): DWR Levee Log, 2002. USACE					
San Joaquin O&M Manual 601.1, 1967, (HLM 11.00)].					
FS Date: 4/9/2014

Pipe, headwall, and flapgate on WS toe.

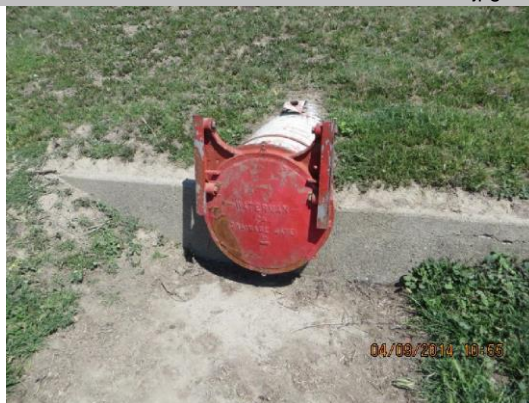
Photo 2 of 3 : UCIP\_SP\_2018\_39255\_60899.jpg

LM Start	10.98	Rating **	M	Issue No.	1230 (cont)
LM End	10.98	Issue Type +	Ma	Location *	
Category	Supplemental			GPS Latitude/Longitude	
				Start	End
Item	DWR UCIP LMA Responsibility			37.282627 °	37.282627 °
				-120.828233 °	-120.828233 °
DWR ID					
Comment Code					
Inspector Comment					
FS_ID:39255 DS_ID:19632 EP_NO: N/A Repair Type: Non-Urgent Crossing Status: Found UCIP Comments: Dense vegetation blocks landward headwall. Recommend removing excess vegetation on landward toe. FIELD_STRUCT_DESC: 24-inch corrugated metal gravity drainage pipe through the levee, 6 feet below the crown. Flap gate on the waterside (WS) end. Brass cap No. 66 bench mark (BM) on the headwall on the landside (LS). [Additional Reference(s): DWR Levee Log, 2002. USACE San Joaquin O&M Manual 601.1, 1967, (HLM 11.00)]. FS Date: 4/9/2014

Pipe, headwall, and flapgate on WS toe.

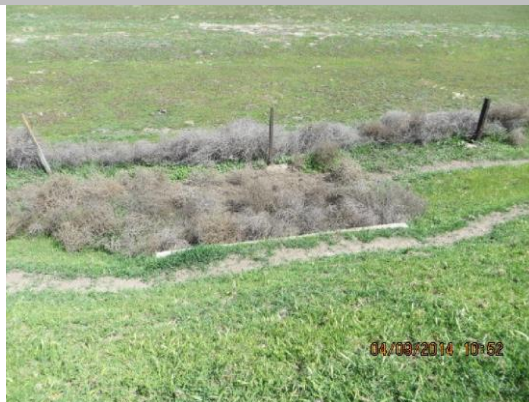
Photo 3 of 3 : UCIP\_SP\_2018\_39255\_60898.jpg

Pipe and headwall on LS toe.

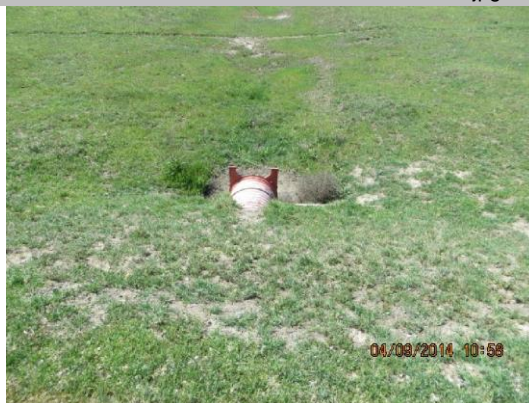
Photo 1 of 3 : UCIP\_SP\_2018\_33690\_60903.jpg

LM Start	11.14	Rating **	A/W	Issue No.	1231
LM End	11.14	Issue Type +	Ma	Location *	
Category	Supplemental			GPS Latitude/Longitude	
				Start	End
Item	DWR UCIP LMA Responsibility			37.281813 °	37.281813 °
				-120.825409 °	-120.825409 °
DWR ID					
Comment Code					
Inspector Comment					
FS_ID:33690 DS_ID:19633 EP_NO: N/A Repair Type: No Action Needed Crossing Status: Found UCIP Comments: FIELD_STRUCT_DESC: 24-inch corrugated metal gravity drainage pipe through the levee, 5 feet below the crown. Flap gate on the waterside (WS) end. Brass cap No. 65 bench mark (BM) on the headwall on the landside (LS). [Additional Reference(s): DWR Levee Log, 2002. USACE San Joaquin O&M Manual 601.1, 1967, (HLM 11.18)]. FS Date: 4/9/2014

Pipe, headwall, and flapgate on WS toe.

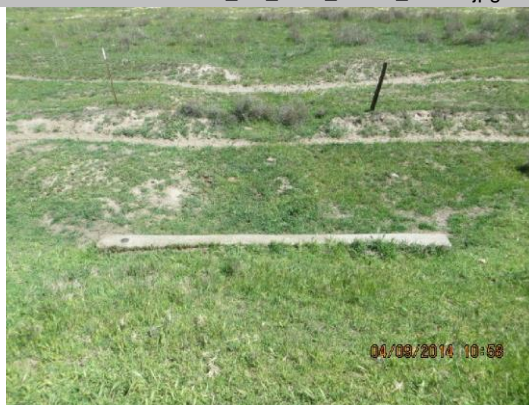
Photo 2 of 3 : UCIP\_SP\_2018\_33690\_60902.jpg

Pipe and headwall at LS toe.

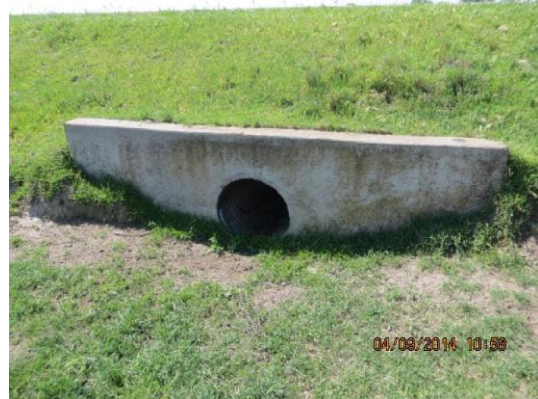
Photo 3 of 3 : UCIP\_SP\_2018\_33690\_60901.jpg

LM Start	11.14	Rating **	A/W	Issue No.	1231 (cont)	
LM End	11.14	Issue Type +	Ma	Location *		
Category	Supplemental			GPS Latitude/Longitude		
				Start	End	
Item	DWR UCIP LMA Responsibility			37.281813 °	37.281813 °	
				-120.825409 °	-120.825409 °	
DWR ID						
Comment Code						
Inspector Comment						
FS_ID:33690						
DS_ID:19633						
EP_NO: N/A						
Repair Type: No Action Needed						
Crossing Status: Found						
UCIP Comments:						
FIELD_STRUCT_DESC: 24-inch corrugated metal gravity drainage pipe						
through the levee, 5 feet below the crown. Flap gate on the waterside						
(WS) end. Brass cap No. 65 bench mark (BM) on the headwall on the						
landside (LS). [Additional Reference(s): DWR Levee Log, 2002. USACE						
San Joaquin O&M Manual 601.1, 1967, (HLM 11.18)].						
FS Date: 4/9/2014

Pipe and headwall at LS toe.

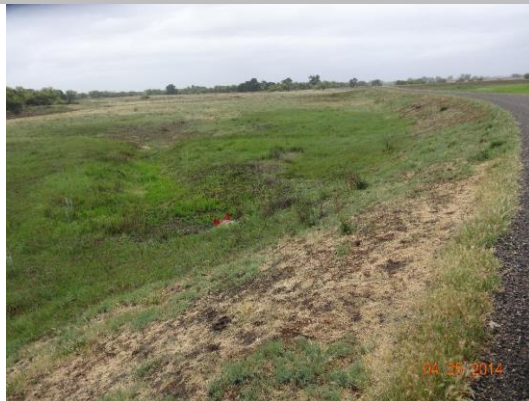
Photo 1 of 3 : UCIP\_SP\_2018\_36103\_65362.jpg

Comment Code					
Inspector Comment					
FS_ID:36103 DS_ID:19634 EP_NO: N/A Repair Type: Non-Urgent Crossing Status: Found UCIP Comments: Need to contact owner--landward side has been buried. It appears that soil was removed from levee toe, immediately upstream, and used to pile soil at landward side at crossing. FIELD_STRUCT_DESC: 24-inch corrugated metal gravity drainage pipe through the levee, 10 feet below the crown. Flap gate on the waterside (WS) end. Brass cap No. 62 bench mark (BM) on the headwall on the landside (LS). [Additional Reference(s): DWR Levee Log, 2002. USACE San Joaquin O&M Manual 601.1, 1967, (HLM 11.48)]. FS Date: 4/25/2014

View of waterward side.

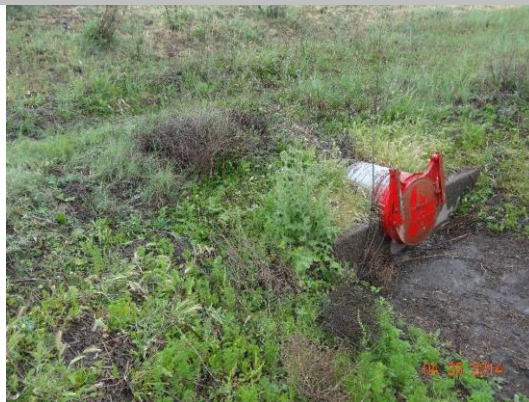
Photo 2 of 3 : UCIP\_SP\_2018\_36103\_65364.jpg

View of concrete headwall and flap gate visible on waterward side.

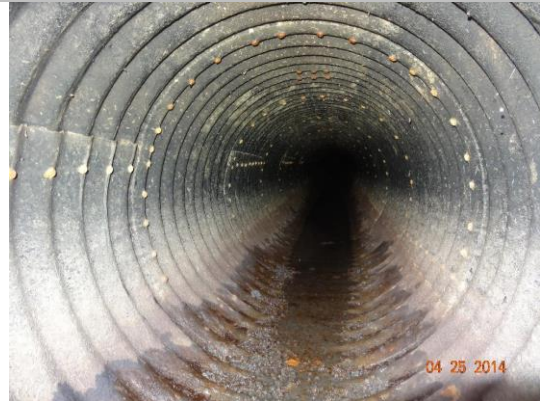
Photo 3 of 3 : UCIP\_SP\_2018\_36103\_65363.jpg

Item	DWR UCIP LMA Responsibility			37.273787 °	37.273787 °	
				-120.825519 °	-120.825519 °	
DWR ID						
Comment Code						
Inspector Comment						
FS_ID:36103 DS_ID:19634 EP_NO: N/A Repair Type: Non-Urgent Crossing Status: Found UCIP Comments: Need to contact owner--landward side has been buried. It appears that soil was removed from levee toe, immediately upstream, and used to pile soil at landward side at crossing. FIELD_STRUCT_DESC: 24-inch corrugated metal gravity drainage pipe through the levee, 10 feet below the crown. Flap gate on the waterside (WS) end. Brass cap No. 62 bench mark (BM) on the headwall on the landside (LS). [Additional Reference(s): DWR Levee Log, 2002. USACE San Joaquin O&M Manual 601.1, 1967, (HLM 11.48)]. FS Date: 4/25/2014

Inside view of pipe from waterward side.

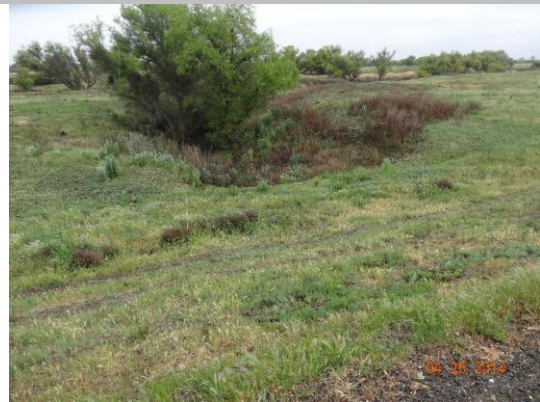
Photo 1 of 3 : UCIP\_SP\_2018\_36105\_65372.jpg

Comment Code						
Inspector Comment						
FS_ID:36105 DS_ID:19635 EP_NO: N/A Repair Type: Non-Urgent Crossing Status: Found UCIP Comments: Crossing is non-functional --landward side is buried. Debris found on landward side (channel). Dense vegetation found on waterward slope. Recommend contacting owner to determine status of crossing. If crossing is no longer used need to coordinate with CVFPB for proper abandonment. FIELD_STRUCT_DESC: 24-inch corrugated metal gravity drainage pipe through the levee, 17 feet below the crown. Flap gate on the waterside (WS) end. Brass cap No. 61 bench mark (BM) on the headwall on the landside (LS). [Additional Reference(s): DWR Levee Log, 2002. USACE San Joaquin O&M Manual 601.1, 1967, (HLM 11.76)]. FS Date: 4/25/2014

View of waterward side.

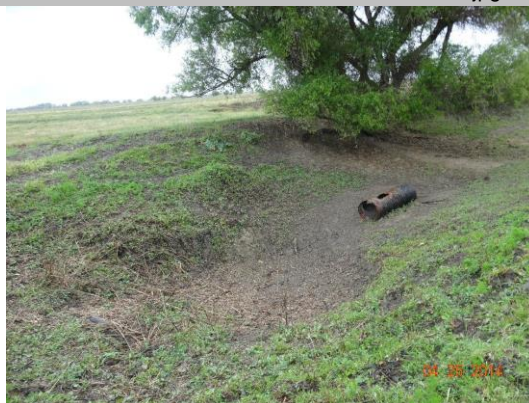
Photo 2 of 3 : UCIP\_SP\_2018\_36105\_65371.jpg

FS\_ID:36105  
DS\_ID:19635  
EP\_NO: N/A  
Repair Type: Non-Urgent  
Crossing Status: Found  
UCIP Comments: Crossing is non-functional --landward side is buried. Debris found on landward side (channel). Dense vegetation found on waterward slope. Recommend contacting owner to determine status of crossing. If crossing is no longer used need to coordinate with CVFPB for proper abandonment.  
FIELD\_STRUCT\_DESC: 24-inch corrugated metal gravity drainage pipe through the levee, 17 feet below the crown. Flap gate on the waterside (WS) end. Brass cap No. 61 bench mark (BM) on the headwall on the landside (LS). [Additional Reference(s): DWR Levee Log, 2002. USACE San Joaquin O&M Manual 601.1, 1967, (HLM 11.76)].  
FS Date: 4/25/2014

Landward side of crossing buried--damage pipe section visible on landward side.

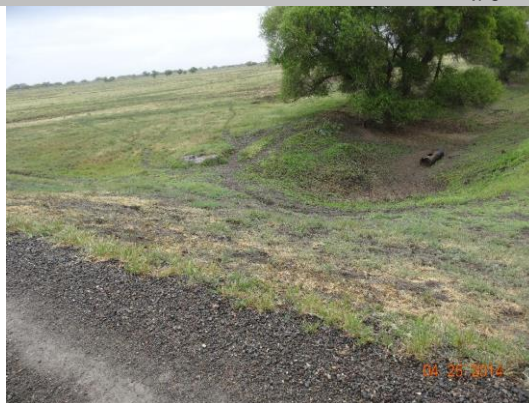
Photo 3 of 3 : UCIP\_SP\_2018\_36105\_65373.jpg

View of landward side.

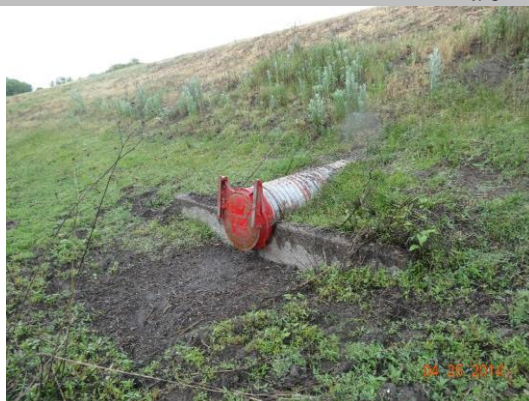
Photo 2 of 3 : UCIP\_SP\_2018\_36106\_65379.jpg

Flap gate and concrete headwall visible on waterward side.

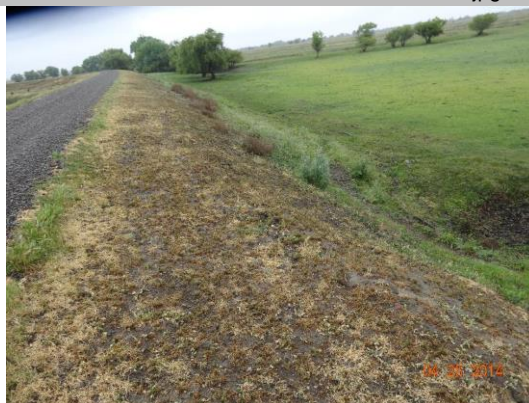
Photo 3 of 3 : UCIP\_SP\_2018\_36106\_65377.jpg

Item	DWR UCIP LMA Responsibility			37.265336 °		37.265336 °
				-120.826591 °		-120.826591 °
DWR ID						
Comment Code						
Inspector Comment						
FS_ID:36106						
DS_ID:19636						
EP_NO: N/A						
Repair Type: Non-Urgent						
Crossing Status: Found						
UCIP Comments: Crossing is non-functional --landward side is buried.						
Dense vegetation found on waterward slope. Recommend contacting owner to determine status of crossing. If crossing is no longer used need to coordinate with CVFPB for proper abandonment.						
FIELD_STRUCT_DESC: 24-inch corrugated metal gravity drainage pipe through the levee, 12.4 feet below the crown. Flap gate on the waterside (WS) end. Brass cap No. 60 bench mark (BM) on the headwall on the landside (LS). [Additional Reference(s): DWR Levee Log, 2002. USACE San Joaquin O&M Manual 601.1, 1967, (HLM 12.11)].						
FS Date: 4/25/2014

View of landward side.

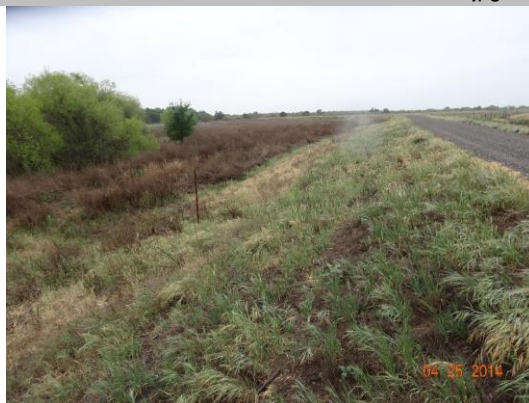
Photo 1 of 3 : UCIP\_SP\_2018\_36146\_65412.jpg

FS\_ID:36146  
DS\_ID:19637  
EP\_NO: N/A  
Repair Type: Non-Urgent  
Crossing Status: Found  
UCIP Comments: Concrete headwall on landward side blocked by debris. Dense vegetation limits the inspector's visibility to identify signs of pipe failure (leaks) along the landward slope. Recommend removing vegetation along pipe alignment to conduct proper inspection of crossing.  
FIELD\_STRUCT\_DESC: 24-inch corrugated metal gravity drainage pipe through the levee, 9.5 feet below the crown. Flap gate on the waterside (WS) end. Brass cap No. 60 bench mark (BM) on the headwall on the landside (LS). [Additional Reference(s): DWR Levee Log, 2002. USACE San Joaquin O&M Manual 601.1, 1967, (HLM 12.94)].  
FS Date: 4/25/2014

View of waterward side.

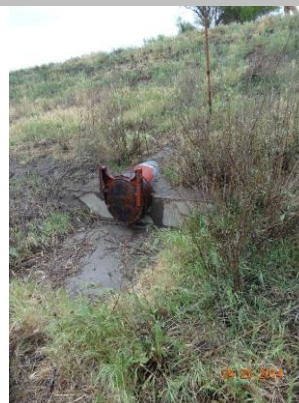
Photo 2 of 3 : UCIP\_SP\_2018\_36146\_65411.jpg

Flap gate and concrete headwall visible on waterward side.

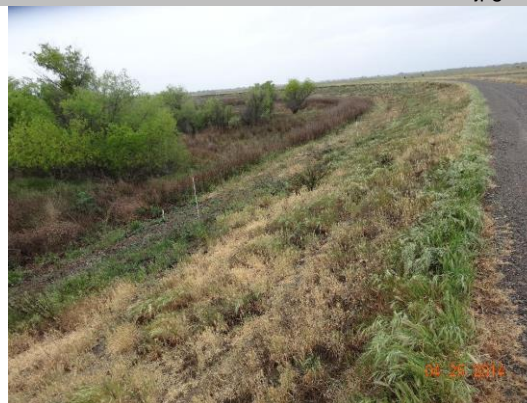
Photo 1 of 3 : UCIP\_SP\_2018\_36109\_65389.jpg

Comment Code					
Inspector Comment					
FS_ID:36109 DS_ID:19638 EP_NO: N/A Repair Type: Non-Urgent Crossing Status: Found UCIP Comments: Dense vegetation limits the inspector's visibility to identify signs of pipe failure (leaks) along the landward slope. Concrete headwall blocked by debris located on landward toe. Recommend clearing debris from landward slope and toe. FIELD_STRUCT_DESC: 24-inch corrugated metal gravity drainage pipe through the levee, 14.2 feet below the crown. Flap gate on the waterside (WS) end. Brass cap No. 60 bench mark (BM) on the headwall on the landside (LS). [Additional Reference(s): DWR Levee Log, 2002. USACE San Joaquin O&M Manual 601.1, 1967, (HLM 13.48)]. FS Date: 4/25/2014

View of waterward side.

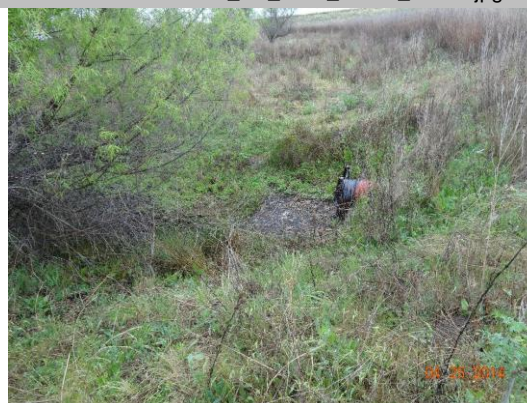
Photo 2 of 3 : UCIP\_SP\_2018\_36109\_65387.jpg

View of flap gate and pipe through levee on waterward side.

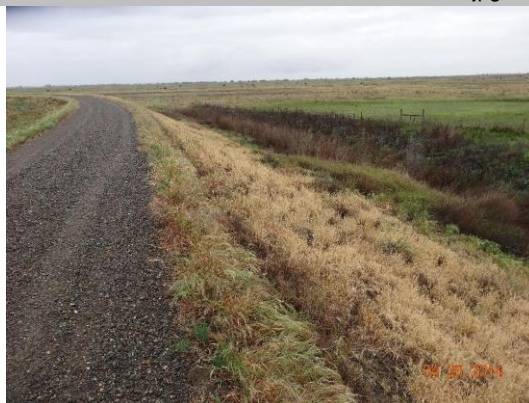
Photo 3 of 3 : UCIP\_SP\_2018\_36109\_65388.jpg

Item	DWR UCIP LMA Responsibility			37.251590 °		37.251590 °
				-120.814354 °		-120.814354 °
DWR ID						
Comment Code						
Inspector Comment						
FS_ID:36109 DS_ID:19638 EP_NO: N/A Repair Type: Non-Urgent Crossing Status: Found UCIP Comments: Dense vegetation limits the inspector's visibility to identify signs of pipe failure (leaks) along the landward slope. Concrete headwall blocked by debris located on landward toe. Recommend clearing debris from landward slope and toe. FIELD_STRUCT_DESC: 24-inch corrugated metal gravity drainage pipe through the levee, 14.2 feet below the crown. Flap gate on the waterside (WS) end. Brass cap No. 60 bench mark (BM) on the headwall on the landside (LS). [Additional Reference(s): DWR Levee Log, 2002. USACE San Joaquin O&M Manual 601.1, 1967, (HLM 13.48)]. FS Date: 4/25/2014

View of landward side.

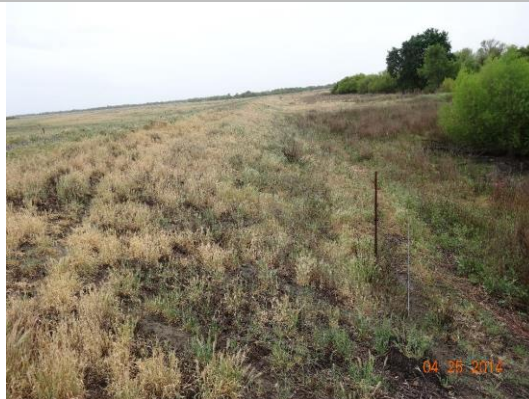
Photo 1 of 3 : UCIP\_SP\_2018\_39256\_65418.jpg

FS\_ID:39256  
DS\_ID:19639  
EP\_NO: N/A  
Repair Type: Non-Urgent  
Crossing Status: Found  
UCIP Comments: No access to waterward toe due to fence. Unable to find the concrete headwall and flap gate on waterward side past fence. Also dense vegetation limits the inspector's visibility to identify signs of pipe failure (leaks) along the waterward slope. Recommend removing vegetation along pipe alignment to conduct proper inspection of structure. Also need access past fence on waterward side.  
FIELD\_STRUCT\_DESC: 24-inch corrugated metal gravity drainage pipe through the levee, 14.5 feet below the crown. Flap gate on the waterside (WS) end. Brass cap No. 60 bench mark (BM) on the headwall on the landside (LS). [Additional Reference(s): DWR Levee Log, 2002. USACE San Joaquin O&M Manual 601.1, 1967, (HLM 13.58)].  
FS Date: 4/25/2014

View of waterward side.

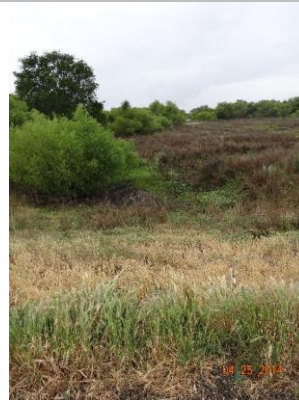
Photo 2 of 3 : UCIP\_SP\_2018\_39256\_65417.jpg

Dense vegetation on waterward side.

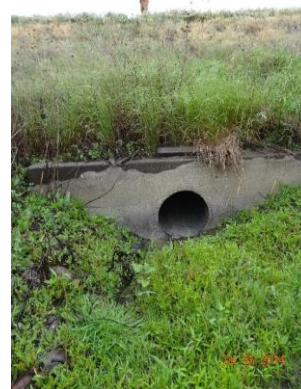
Photo 3 of 3 : UCIP\_SP\_2018\_39256\_65416.jpg

Item	DWR UCIP LMA Responsibility			37.250138 °	37.250138 °	
				-120.814720 °	-120.814720 °	
DWR ID						
Comment Code						
Inspector Comment						
FS_ID:39256 DS_ID:19639 EP_NO: N/A Repair Type: Non-Urgent Crossing Status: Found UCIP Comments: No access to waterward toe due to fence. Unable to find the concrete headwall and flap gate on waterward side past fence. Also dense vegetation limits the inspector's visibility to identify signs of pipe failure (leaks) along the waterward slope. Recommend removing vegetation along pipe alignment to conduct proper inspection of structure. Also need access past fence on waterward side. FIELD_STRUCT_DESC: 24-inch corrugated metal gravity drainage pipe through the levee, 14.5 feet below the crown. Flap gate on the waterside (WS) end. Brass cap No. 60 bench mark (BM) on the headwall on the landside (LS). [Additional Reference(s): DWR Levee Log, 2002. USACE San Joaquin O&M Manual 601.1, 1967, (HLM 13.58)]. FS Date: 4/25/2014

Concrete headwall visible from landward side.

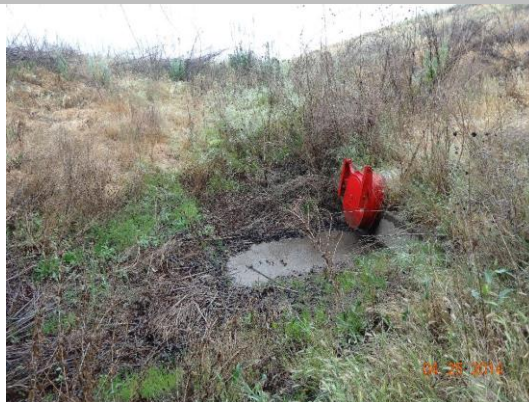
Photo 2 of 3 : UCIP\_SP\_2018\_36166\_65452.jpg

View of concrete headwall, concrete apron, and flap gate on waterward side.

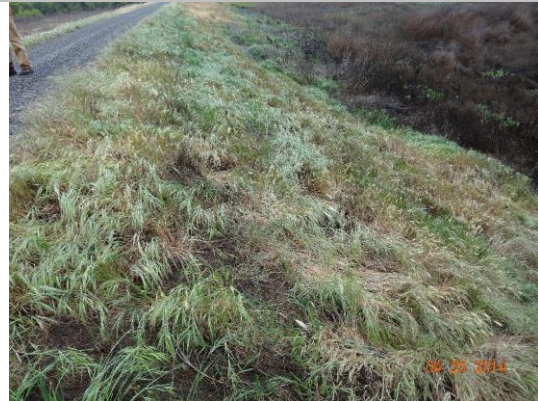
Photo 3 of 3 : UCIP\_SP\_2018\_36166\_65448.jpg

Item	DWR UCIP LMA Responsibility			37.242225 °	37.242225 °	
				-120.817665 °	-120.817665 °	
DWR ID						
Comment Code						
Inspector Comment						
FS_ID:36166 DS_ID:19641 EP_NO: N/A Repair Type: Non-Urgent Crossing Status: Found UCIP Comments: Dense vegetation limits the inspector's visibility to identify signs of pipe failure (leaks) along the slopes. Recommend removing vegetation along pipe alignment to conduct proper inspection of structure. FIELD_STRUCT_DESC: 24-inch corrugated metal gravity drainage pipe through the levee, 13 feet below the crown. Flap gate on the waterside (WS) end. Brass cap No. 60 bench mark (BM) on the headwall on the landside (LS). [Additional Reference(s): DWR Levee Log, 2002. USACE San Joaquin O&M Manual 601.1, 1967, (HLM 14.21)]. FS Date: 4/25/2014

View of landward side.

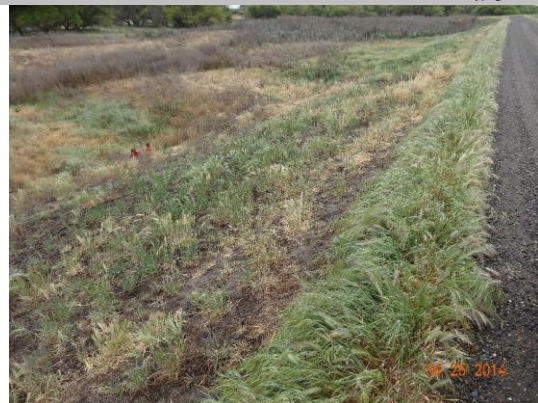
Photo 1 of 3 : UCIP\_SP\_2018\_36167\_65455.jpg

Comment Code						
Inspector Comment						
FS_ID:36167 DS_ID:19642 EP_NO: N/A Repair Type: Non-Urgent Crossing Status: Found UCIP Comments: Dense vegetation limits the inspector's visibility to identify signs of pipe failure (leaks) along the landward slope and toe. Recommend removing vegetation along pipe alignment to conduct proper inspection of structure. FIELD_STRUCT_DESC: 24-inch corrugated metal gravity drainage pipe through the levee, 9.7 feet below the crown. Flap gate on the waterside (WS) end. Brass cap No. 60 bench mark (BM) on the headwall on the landside (LS). [Additional Reference(s): DWR Levee Log, 2002. USACE San Joaquin O&M Manual 601.1, 1967, (HLM 14.65)]. FS Date: 4/25/2014

View of waterward side.

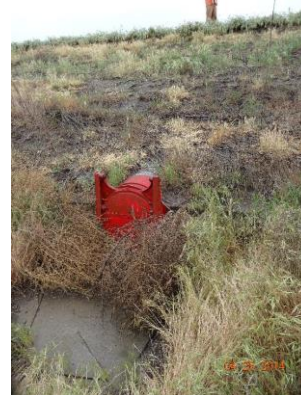
Photo 2 of 3 : UCIP\_SP\_2018\_36167\_65454.jpg

Flap gate, concrete headwall, and concrete apron located on waterward toe.

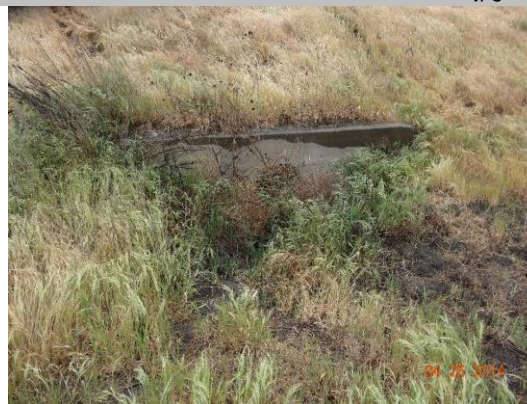
Photo 3 of 3 : UCIP\_SP\_2018\_36167\_65453.jpg

Concrete headwall located on landward toe.

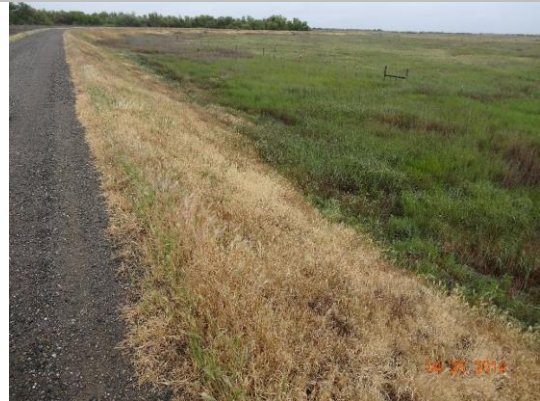
Photo 3 of 3 : UCIP\_SP\_2018\_36168\_65458.jpg

Item	DWR UCIP LMA Responsibility			37.231428 °	37.231428 °	
				-120.805543 °	-120.805543 °	
DWR ID						
Comment Code						
Inspector Comment						
FS_ID:36168 DS_ID:19643 EP_NO: N/A Repair Type: Non-Urgent Crossing Status: Found UCIP Comments: Dense vegetation limits the inspector's visibility to identify signs of pipe failure (leaks) along the landward slope. Recommend removing vegetation along pipe alignment to conduct proper inspection of structure. FIELD_STRUCT_DESC: 24-inch corrugated metal gravity drainage pipe through the levee, 9.2 feet below the crown. Flap gate on the waterside (WS) end. Brass cap No. 60 bench mark (BM) on the headwall on the landside (LS). [Additional Reference(s): DWR Levee Log, 2002. USACE San Joaquin O&M Manual 601.1, 1967, (HLM 15.29)]. FS Date: 4/25/2014

View of landward side.

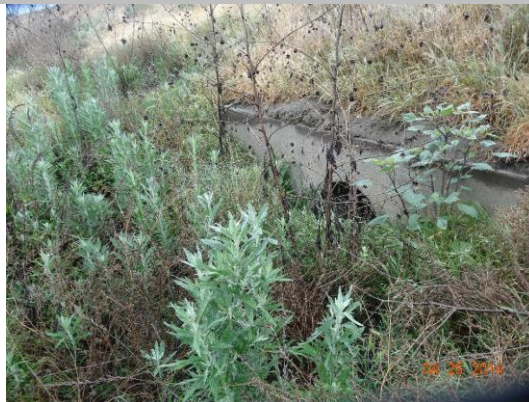
Photo 3 of 3 : UCIP\_SP\_2018\_36169\_65462.jpg

Concrete headwall visible on landward toe--dense vegetation blocking inlet.

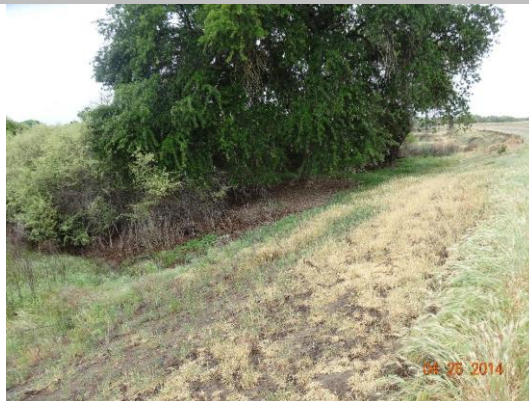
Photo 1 of 3 : UCIP\_SP\_2018\_36171\_65471.jpg

FS\_ID:36171  
DS\_ID:19645  
EP\_NO: N/A  
Repair Type: Non-Urgent  
Crossing Status: Found  
UCIP Comments: Dense vegetation limits the inspector's visibility to identify signs of pipe failure (leaks) along the waterward and landward slope. Recommend removing vegetation along pipe alignment to conduct proper inspection of structure.  
FIELD\_STRUCT\_DESC: 24-inch corrugated metal gravity drainage pipe through the levee, 11 feet below the crown. Flap gate on the waterside (WS) end. Brass cap No. 60 bench mark (BM) on the headwall on the landside (LS). [Additional Reference(s): DWR Levee Log, 2002. USACE San Joaquin O&M Manual 601.1, 1967, (HLM 15.81)].  
FS Date: 4/25/2014

View of waterward side.

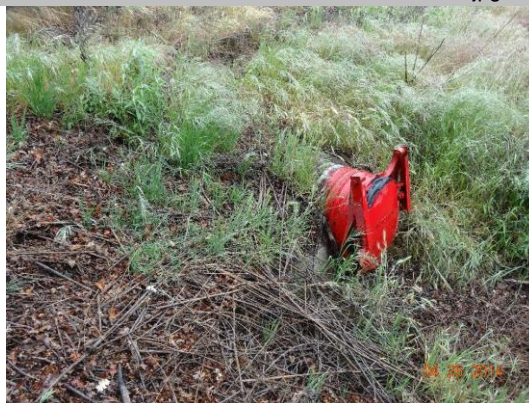
Photo 3 of 3 : UCIP\_SP\_2018\_36171\_65469.jpg

Item	DWR UCIP LMA Responsibility			37.226099 °		37.226099 °
				-120.799125 °		-120.799125 °
DWR ID						
Comment Code						
Inspector Comment						
FS_ID:36171 DS_ID:19645 EP_NO: N/A Repair Type: Non-Urgent Crossing Status: Found UCIP Comments: Dense vegetation limits the inspector's visibility to identify signs of pipe failure (leaks) along the waterward and landward slope. Recommend removing vegetation along pipe alignment to conduct proper inspection of structure. FIELD_STRUCT_DESC: 24-inch corrugated metal gravity drainage pipe through the levee, 11 feet below the crown. Flap gate on the waterside (WS) end. Brass cap No. 60 bench mark (BM) on the headwall on the landside (LS). [Additional Reference(s): DWR Levee Log, 2002. USACE San Joaquin O&M Manual 601.1, 1967, (HLM 15.81)]. FS Date: 4/25/2014

Side view of pipe and flap gate on waterward side.

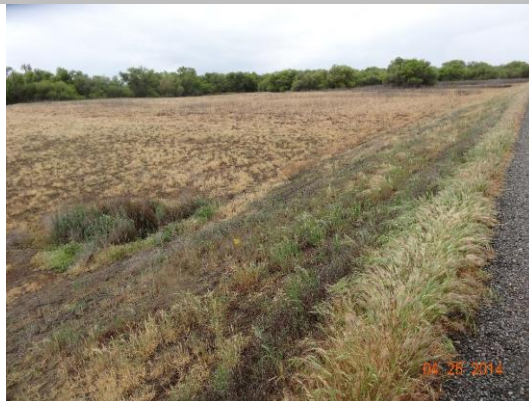
Photo 1 of 3 : UCIP\_SP\_2018\_36172\_65476.jpg

Comment Code						
Inspector Comment						
FS_ID:36172 DS_ID:19646 EP_NO: N/A Repair Type: Non-Urgent Crossing Status: Found UCIP Comments: Dense vegetation limits the inspector's visibility to identify signs of pipe failure (leaks) along the waterward and landward slopes. Recommend removing vegetation along pipe alignment to conduct proper inspection of structure and appurtenances. FIELD_STRUCT_DESC: 24-inch corrugated metal gravity drainage pipe through the levee, 11.3 feet below the crown. Flap gate on the waterside (WS) end. Brass cap No. 50 bench mark (BM) on the headwall on the landside (LS). [Additional Reference(s): DWR Levee Log, 2002. USACE San Joaquin O&M Manual 601.1, 1967, (HLM 16.09)]. FS Date: 4/25/2014

View of waterward side.
