**Flood Control Project Maintenance  
Levee Inspections**

## Maintenance Issue Types Only, Levee Inspection Report By Mile - Spring 2018

### Lower San Joaquin Levee District

Waterway	Bank	Unit Miles	Inspection Start/End	Inspector
Unit No. 01 San Joaquin River	Right	22.52	04/04/2018 04/16/2018	Richard Willoughby

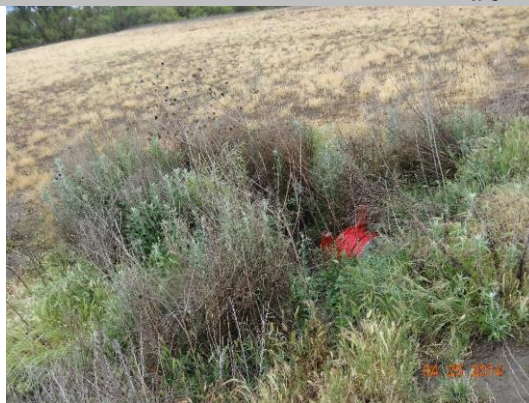
Photo 2 of 3 : UCIP\_SP\_2018\_36172\_65475.jpg

Flap gate visible on waterward toe.

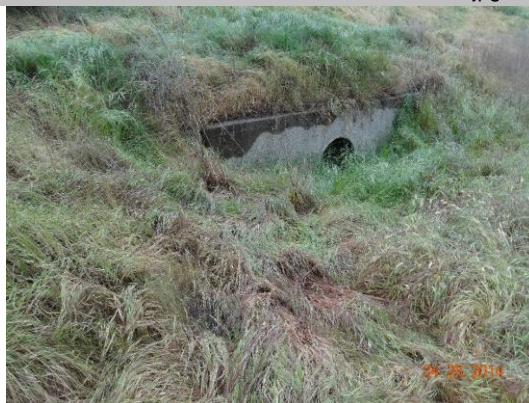
Photo 3 of 3 : UCIP\_SP\_2018\_36172\_65474.jpg

Item	DWR UCIP LMA Responsibility			37.224157 °		37.224157 °
				-120.795250 °		-120.795250 °
DWR ID						
Comment Code						
Inspector Comment						
FS_ID:36172						
DS_ID:19646						
EP_NO: N/A						
Repair Type: Non-Urgent						
Crossing Status: Found						
UCIP Comments: Dense vegetation limits the inspector's visibility to identify signs of pipe failure (leaks) along the waterward and landward slopes. Recommend removing vegetation along pipe alignment to conduct proper inspection of structure and appurtenances.						
FIELD_STRUCT_DESC: 24-inch corrugated metal gravity drainage pipe through the levee, 11.3 feet below the crown. Flap gate on the waterside (WS) end. Brass cap No. 50 bench mark (BM) on the headwall on the landside (LS). [Additional Reference(s): DWR Levee Log, 2002. USACE San Joaquin O&M Manual 601.1, 1967, (HLM 16.09)].						
FS Date: 4/25/2014

View of landward side.

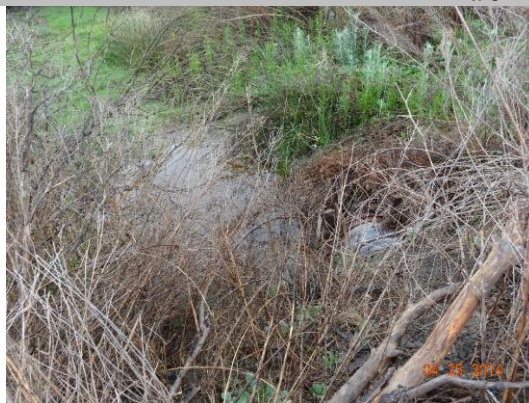
Photo 2 of 3 : UCIP\_SP\_2018\_39257\_65479.jpg

Crossing visible on waterward side under dense vegetation.

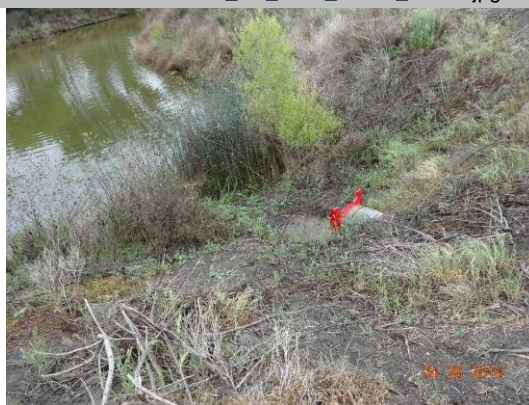
Photo 2 of 3 : UCIP\_SP\_2018\_39258\_66289.jpg

View of waterward side.

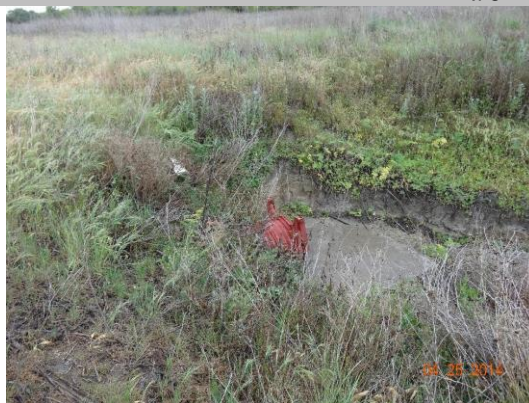
Photo 2 of 3 : UCIP\_SP\_2018\_39259\_65519.jpg

Flap gate visible on waterward side.

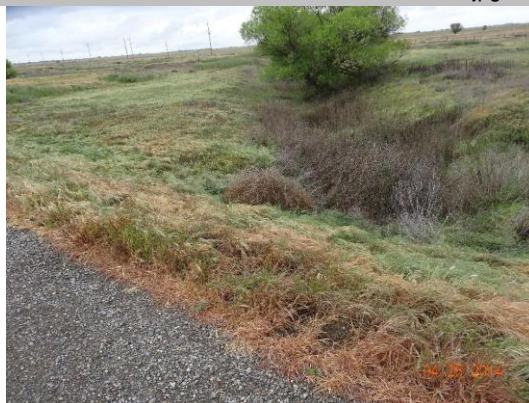
Photo 3 of 3 : UCIP\_SP\_2018\_39259\_65517.jpg

Item	DWR UCIP LMA Responsibility			37.221838 °	37.221838 °	
				-120.780230 °	-120.780230 °	
DWR ID						
Comment Code						
Inspector Comment						
FS_ID:39259 DS_ID:19577 EP_NO: N/A Repair Type: Non-Urgent Crossing Status: Found UCIP Comments: Dense vegetation limits the inspector's visibility to identify signs of pipe failure (leaks) along the waterward and landward slopes. Concrete headwall is buried by dense vegetation. Recommend removing vegetation along pipe alignment to conduct proper inspection of structure. FIELD_STRUCT_DESC: 24-inch corrugated metal gravity drainage pipe through the levee, 11.5 feet below the crown. Flap gate on the waterside (WS) end. Brass cap No. 50 bench mark (BM) on the headwall on the landside (LS). [Additional Reference(s): DWR Levee Log, 2002. USACE San Joaquin O&M Manual 601.1, 1967, (HLM 17.01)]. FS Date: 4/25/2014

View of landward side.

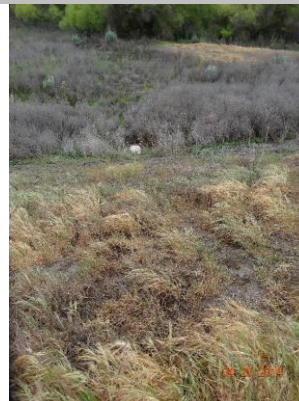
Photo 1 of 3 : UCIP\_SP\_2018\_39260\_65525.jpg

FS\_ID:39260  
DS\_ID:19578  
EP\_NO: N/A  
Repair Type: Non-Urgent  
Crossing Status: Found  
UCIP Comments: Dense vegetation limits the inspector's visibility to identify signs of pipe failure (leaks) along the waterward and landward slopes. Recommend removing vegetation along pipe alignment to conduct proper inspection of structure. Sediment buildup inside pipe visible from landward side. Recommend clearing pipe.  
FIELD\_STRUCT\_DESC: 24-inch corrugated metal gravity drainage pipe through the levee, 11.5 feet below the crown. Flap gate on the waterside (WS) end. Brass cap No. 50 bench mark (BM) on the headwall on the landside (LS). [Additional Reference(s): DWR Levee Log, 2002. USACE San Joaquin O&M Manual 601.1, 1967, (HLM 17.19)].  
FS Date: 4/25/2014

View of waterward side.

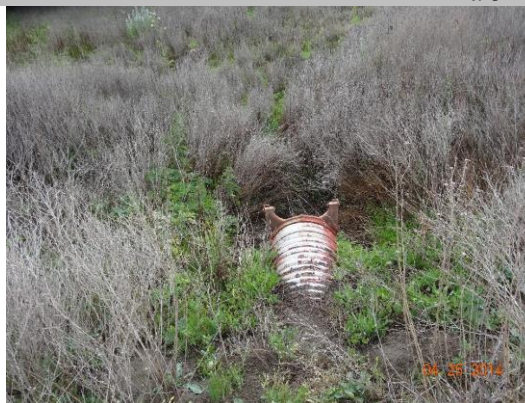
Photo 2 of 3 : UCIP\_SP\_2018\_39260\_65521.jpg

Pipe visible on waterward side.

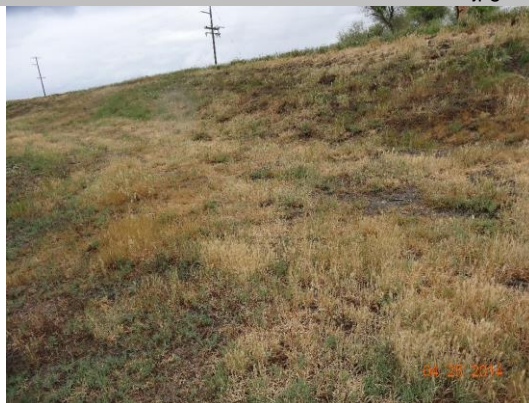
Photo 1 of 3 : UCIP\_SP\_2018\_36203\_65551.jpg

Comment Code					
Inspector Comment					
FS_ID:36203 DS_ID:19579 EP_NO: N/A Repair Type: Non-Urgent Crossing Status: Found UCIP Comments: Dense vegetation limits the inspector's visibility to identify signs of pipe failure (leaks) along the waterward and landward slope. Recommend removing vegetation along pipe alignment to conduct proper inspection of structure. FIELD_STRUCT_DESC: 24-inch corrugated metal gravity drainage pipe through the levee, 15.8 feet below the crown. Flap gate on the waterside (WS) end. Brass cap No. 50 bench mark (BM) on the headwall on the landside (LS). [Additional Reference(s): DWR Levee Log, 2002. USACE San Joaquin O&M Manual 601.1, 1967, (HLM 17.26)]. FS Date: 4/25/2014

View of waterward slope.

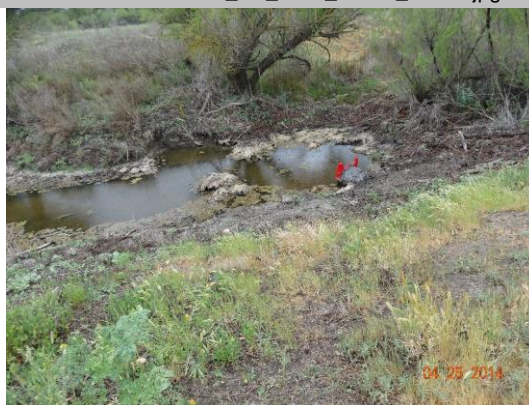
Photo 2 of 3 : UCIP\_SP\_2018\_36203\_65552.jpg

Pipe visible on waterward side.

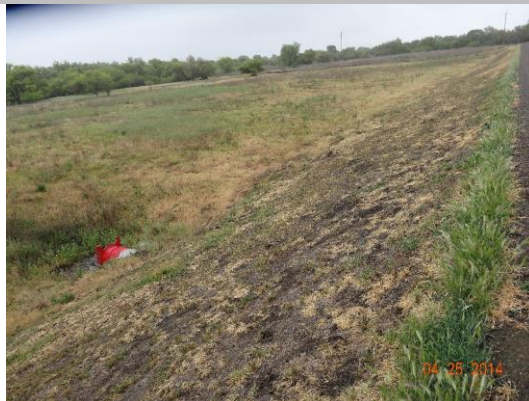
Photo 1 of 3 : UCIP\_SP\_2018\_36204\_65547.jpg

FS\_ID:36204  
DS\_ID:19580  
EP\_NO: N/A  
Repair Type: Non-Urgent  
Crossing Status: Found  
UCIP Comments: Dense vegetation limits the inspector's visibility to identify signs of pipe failure (leaks) along the landward slope. Recommend removing vegetation along pipe alignment to conduct proper inspection of structure.  
FIELD\_STRUCT\_DESC: 24-inch corrugated metal gravity drainage pipe through the levee, 9.5 feet below the crown. Flap gate on the waterside (WS) end. Brass cap No. 50 bench mark (BM) on the headwall on the landside (LS). [Additional Reference(s): DWR Levee Log, 2002. USACE San Joaquin O&M Manual 601.1, 1967, (HLM 17.53)].  
FS Date: 4/25/2014

View of waterward side.

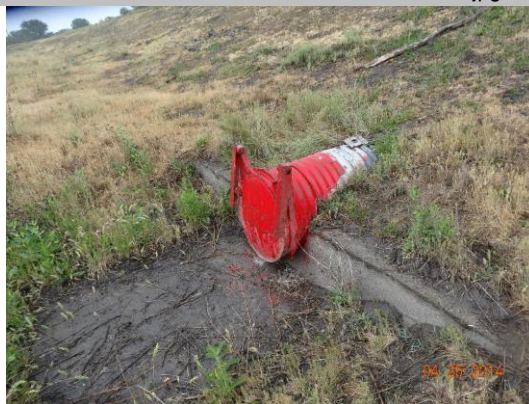
Photo 2 of 3 : UCIP\_SP\_2018\_36204\_65546.jpg

Flap gate visible on waterward side.

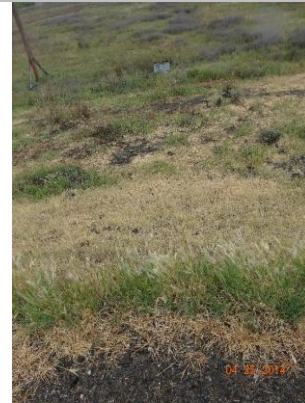
Photo 3 of 3 : UCIP\_SP\_2018\_36204\_65545.jpg

Item	DWR UCIP LMA Responsibility			37.215976 °	37.215976 °	
				-120.777615 °	-120.777615 °	
DWR ID						
Comment Code						
Inspector Comment						
FS_ID:36204						
DS_ID:19580						
EP_NO: N/A						
Repair Type: Non-Urgent						
Crossing Status: Found						
UCIP Comments: Dense vegetation limits the inspector's visibility to identify signs of pipe failure (leaks) along the landward slope.						
Recommend removing vegetation along pipe alignment to conduct proper inspection of structure.						
FIELD_STRUCT_DESC: 24-inch corrugated metal gravity drainage pipe through the levee, 9.5 feet below the crown. Flap gate on the waterside (WS) end. Brass cap No. 50 bench mark (BM) on the headwall on the landside (LS). [Additional Reference(s): DWR Levee Log, 2002. USACE San Joaquin O&M Manual 601.1, 1967, (HLM 17.53)].						
FS Date: 4/25/2014

View of landward side--riser at levee toe.

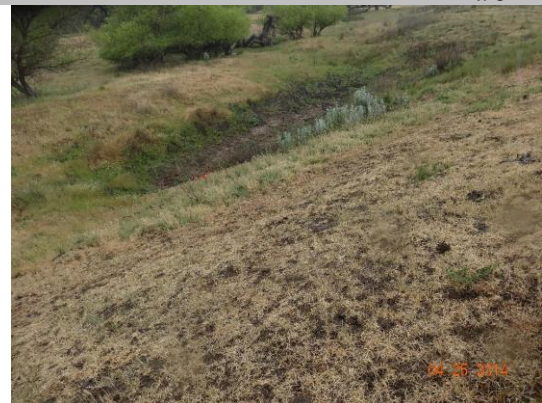
Photo 1 of 3 : UCIP\_SP\_2018\_39261\_65557.jpg

Comment Code						
Inspector Comment						
FS_ID:39261						
DS_ID:19581						
EP_NO: N/A						
Repair Type: Non-Urgent						
Crossing Status: Found						
UCIP Comments: Need to contact owner. Recommend investigating integrity of pipe wall through levee heavy corrosion visible from landward side.						
FIELD_STRUCT_DESC: 24-inch corrugated metal gravity drainage pipe through the levee, 11.5 feet below the crown. Flap gate on the waterside (WS) end. Brass cap No. 50 bench mark (BM) on the headwall on the landside (LS). [Additional Reference(s): DWR Levee Log, 2002. USACE San Joaquin O&M Manual 601.1, 1967, (HLM 18.19)].						
FS Date: 4/25/2014

View of waterward side.

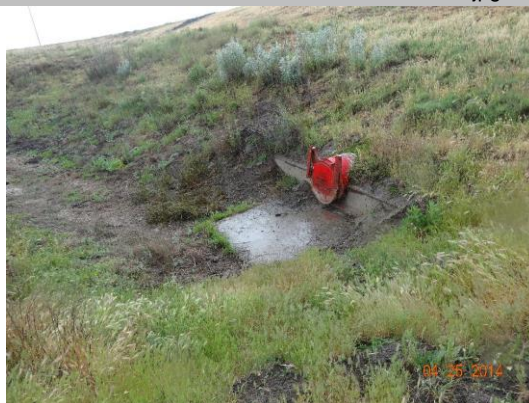
Photo 2 of 3 : UCIP\_SP\_2018\_39261\_65556.jpg

LM Start	18.18	Rating **	M	Issue No.	1253 (cont)	
LM End	18.18	Issue Type +	Ma	Location *		
Category	Supplemental			GPS Latitude/Longitude		
				Start		End
Item	DWR UCIP LMA Responsibility			37.210998 °	37.210998 °	
				-120.768900 °	-120.768900 °	
DWR ID						
Comment Code						
Inspector Comment						
FS_ID:39261 DS_ID:19581 EP_NO: N/A Repair Type: Non-Urgent Crossing Status: Found UCIP Comments: Need to contact owner. Recommend investigating integrity of pipe wall through levee heavy corrosion visible from landward side. FIELD_STRUCT_DESC: 24-inch corrugated metal gravity drainage pipe through the levee, 11.5 feet below the crown. Flap gate on the waterside (WS) end. Brass cap No. 50 bench mark (BM) on the headwall on the landside (LS). [Additional Reference(s): DWR Levee Log, 2002. USACE San Joaquin O&M Manual 601.1, 1967, (HLM 18.19)]. FS Date: 4/25/2014

Flap gate visible on waterward side.

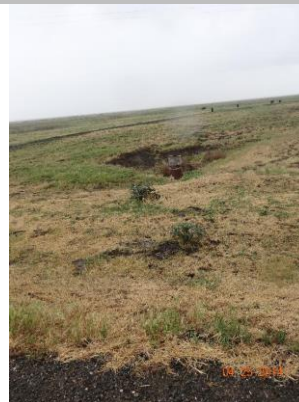
Photo 3 of 3 : UCIP\_SP\_2018\_39261\_65555.jpg

View of landward side.

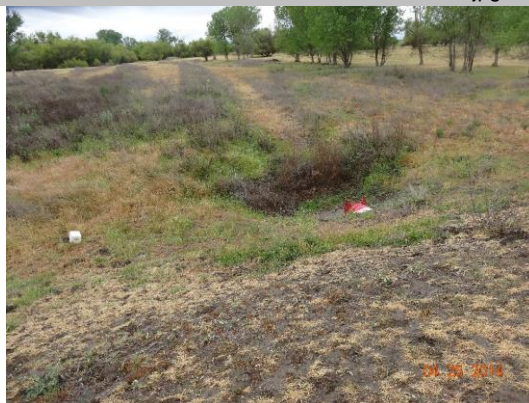
Photo 1 of 3 : UCIP\_SP\_2018\_36206\_65563.jpg

LM Start	18.45	Rating **	A/W	Issue No.	1254	
LM End	18.45	Issue Type +	Ma	Location *		
Category	Supplemental			GPS Latitude/Longitude		
				Start	End	
Item	DWR UCIP LMA Responsibility			37.207538 °	37.207538 °	
				-120.767679 °	-120.767679 °	
DWR ID						
Comment Code						
Inspector Comment						
FS_ID:36206						
DS_ID:19582						
EP_NO: N/A						
Repair Type: No Action Needed						
Crossing Status: Found						
UCIP Comments:						
FIELD_STRUCT_DESC: 24-inch corrugated metal gravity drainage pipe						
through the levee, 9.4 feet below the crown. Flap gate on the waterside						
(WS) end. Brass cap No. 50 bench mark (BM) on the headwall on the						
landside (LS). [Additional Reference(s): DWR Levee Log, 2002. USACE						
San Joaquin O&M Manual 601.1, 1967, (HLM 18.45)].						
FS Date: 4/25/2014

View of waterward side.

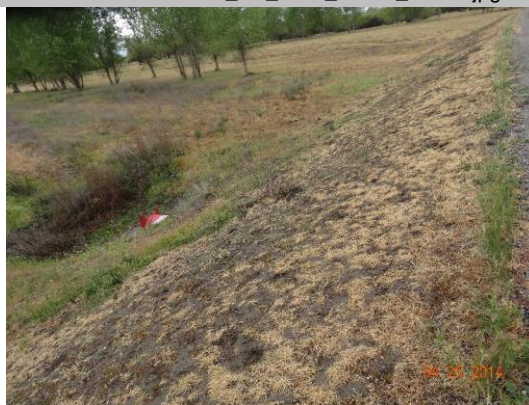
Photo 2 of 3 : UCIP\_SP\_2018\_36206\_65562.jpg

View of waterward slope.

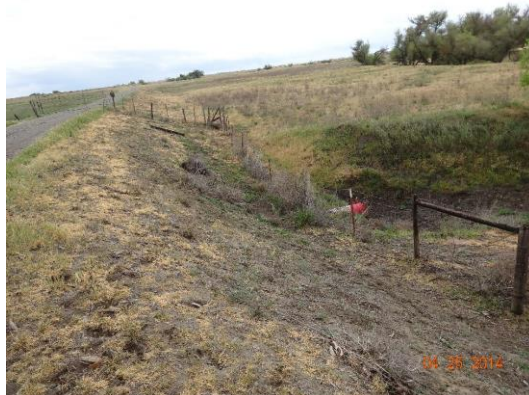
Photo 2 of 3 : UCIP\_SP\_2018\_36246\_65623.jpg

FS\_ID:36246  
DS\_ID:19593  
EP\_NO: N/A  
Repair Type: Non-Urgent  
Crossing Status: Found  
UCIP Comments: Dense vegetation limits the inspector's visibility to identify signs of pipe failure (leaks) along the landward slope. Recommend removing vegetation along pipe alignment to conduct proper inspection of structure.  
FIELD\_STRUCT\_DESC: 24-inch corrugated metal gravity drainage pipe through the levee, 12 feet below the crown. Flap gate on the waterside (WS) end. Brass cap No. 50 bench mark (BM) on the headwall on the landside (LS). [Additional Reference(s): DWR Levee Log, 2002. USACE San Joaquin O&M Manual 601.1, 1967, (HLM 18.79)].  
FS Date: 4/25/2014

View of waterward side.

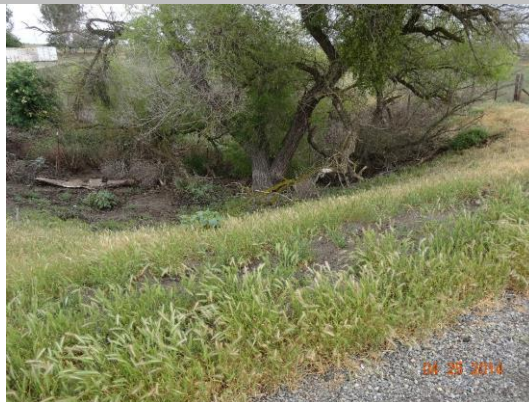
Photo 3 of 3 : UCIP\_SP\_2018\_36246\_65626.jpg

Overview of landward side.

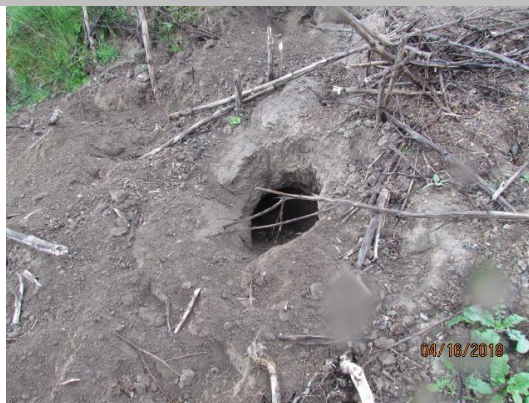
Photo 1 of 2 : SP\_2018\_NA0010\_118\_94\_20180420\_00274.jpg

LM Start	<b>18.79</b>	Rating **	U	Issue No.	<b>94 (cont)</b>
LM End	<b>18.79</b>	Issue Type +	Ma	Location *	LS

Looking at large rodent hole on landward slope. (Spring 2018)

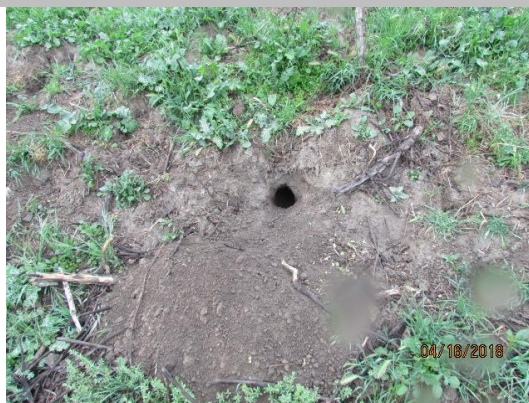
Photo 2 of 2 : SP\_2018\_NA0010\_118\_94\_20180420\_00275.jpg

Looking at typical view of rodent holes with this section. (Spring 2018)

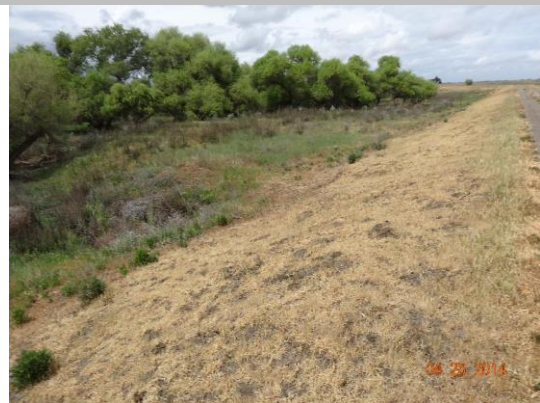
Photo 1 of 3 : UCIP\_SP\_2018\_39269\_65648.jpg

LM Start	20.18	Rating **	M	Issue No.	1261	
LM End	20.18	Issue Type +	Ma	Location *		
Category	Supplemental			GPS Latitude/Longitude		
				Start		End
Item	DWR UCIP LMA Responsibility			37.194669 °		37.194669 °
				-120.759736 °		-120.759736 °
DWR ID						
Comment Code						
Inspector Comment						
FS_ID:39269 DS_ID:19598 EP_NO: N/A Repair Type: Non-Urgent Crossing Status: Found UCIP Comments: Recommend removing vegetation and sediment buildup from both waterward and landward concrete headwalls. FIELD_STRUCT_DESC: 24-inch corrugated metal gravity drainage pipe through the levee, 8.5 feet below the crown. Flap gate on the waterside (WS) end. Brass cap No. 40 bench mark (BM) on the headwall on the landside (LS). [Additional Reference(s): DWR Levee Log, 2002. USACE San Joaquin O&M Manual 601.1, 1967, (HLM 20.18)]. FS Date: 4/25/2014

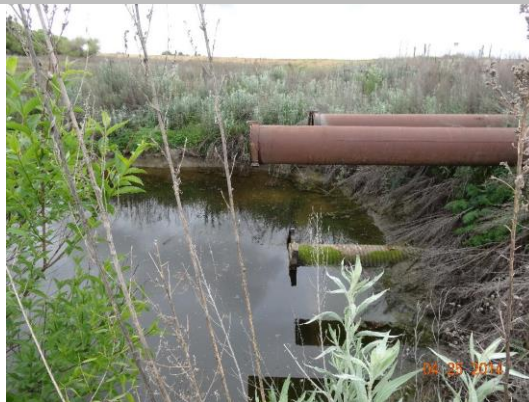
Photo 2 of 3 : UCIP\_SP\_2018\_39878\_66309.jpg

FS\_ID:39878  
DS\_ID:19600  
EP\_NO: N/A  
Repair Type: Non-Urgent  
Crossing Status: Found  
UCIP Comments: Crossing partially submersed--no signs of failure of pipe present along pipe alignment. Recommend contacting owner to determine status of crossing and condition.  
FIELD\_STRUCT\_DESC: 36-inch corrugated metal gravity drainage pipe through the levee, 10.5 feet below the crown. Flap gate on the waterside (WS) end. Brass cap No. 40 bench mark (BM) on the headwall on the landside (LS). [Additional Reference(s): DWR Levee Log, 2002. USACE San Joaquin O&M Manual 601.1, 1967, (HLM 20.27)].  
FS Date: 4/25/2014

Multiple crossings visible on waterward side--36 inch CMP is submersed in water.

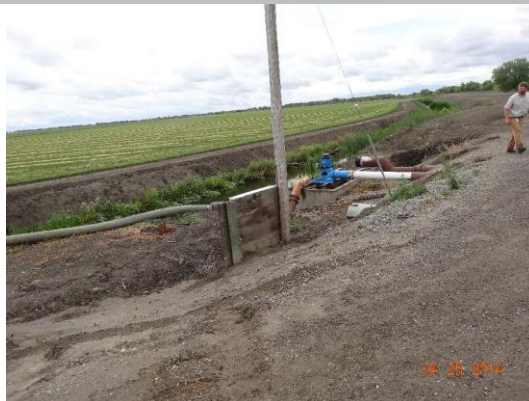
Photo 3 of 3 : UCIP\_SP\_2018\_39878\_66307.jpg

Item	DWR UCIP LMA Responsibility			37.193542 °	37.193542 °	
				-120.760300 °	-120.760300 °	
DWR ID						
Comment Code						
Inspector Comment						
FS_ID:39878 DS_ID:19600 EP_NO: N/A Repair Type: Non-Urgent Crossing Status: Found UCIP Comments: Crossing partially submersed--no signs of failure of pipe present along pipe alignment. Recommend contacting owner to determine status of crossing and condition. FIELD_STRUCT_DESC: 36-inch corrugated metal gravity drainage pipe through the levee, 10.5 feet below the crown. Flap gate on the waterside (WS) end. Brass cap No. 40 bench mark (BM) on the headwall on the landside (LS). [Additional Reference(s): DWR Levee Log, 2002. USACE San Joaquin O&M Manual 601.1, 1967, (HLM 20.27)]. FS Date: 4/25/2014

View of landward side.

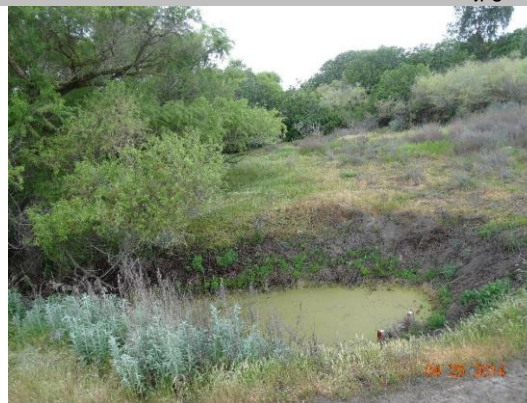
Photo 1 of 3 : UCIP\_SP\_2018\_39271\_66312.jpg

Comment Code					
Inspector Comment					
FS_ID:39271 DS_ID:19603 EP_NO: N/A Repair Type: Non-Urgent Crossing Status: Found UCIP Comments: Crossing is non-functional--crossing buried on landward side. Need to contact owner to determine status of crossing. If crossing is no longer used need to coordinate with CVFPB for proper abandonment. FIELD_STRUCT_DESC: 36-inch corrugated metal gravity drainage pipe through the levee, 11.5 feet below the crown. Flap gate on the waterside (WS) end. Brass cap No. 40 bench mark (BM) on the headwall on the landside (LS). [Additional Reference(s): DWR Levee Log, 2002. USACE San Joaquin O&M Manual 601.1, 1967, (HLM 21.40)]. FS Date: 4/25/2014

View of waterward side.

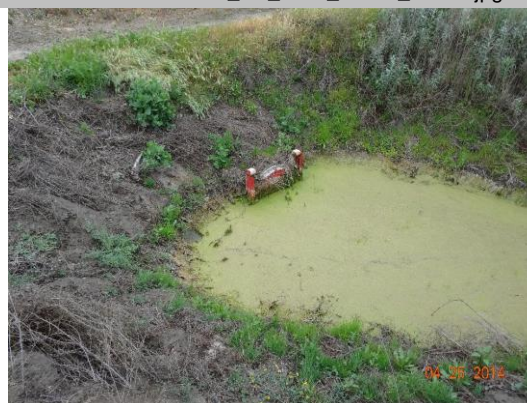
Photo 2 of 3 : UCIP\_SP\_2018\_39271\_66313.jpg

Flap gate half way submersed located on waterward side.

Item	DWR UCIP LMA Responsibility			37.179065 °	37.179065 °	
				-120.761567 °	-120.761567 °	
DWR ID						
Comment Code						
Inspector Comment						
FS_ID:39271 DS_ID:19603 EP_NO: N/A Repair Type: Non-Urgent Crossing Status: Found UCIP Comments: Crossing is non-functional--crossing buried on landward side. Need to contact owner to determine status of crossing. If crossing is no longer used need to coordinate with CVFPB for proper abandonment. FIELD_STRUCT_DESC: 36-inch corrugated metal gravity drainage pipe through the levee, 11.5 feet below the crown. Flap gate on the waterside (WS) end. Brass cap No. 40 bench mark (BM) on the headwall on the landside (LS). [Additional Reference(s): DWR Levee Log, 2002. USACE San Joaquin O&M Manual 601.1, 1967, (HLM 21.40)]. FS Date: 4/25/2014

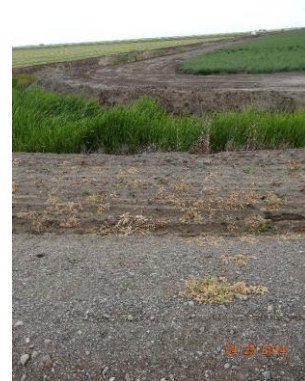
Photo 3 of 3 : UCIP\_SP\_2018\_39271\_66311.jpg

View of landward side.

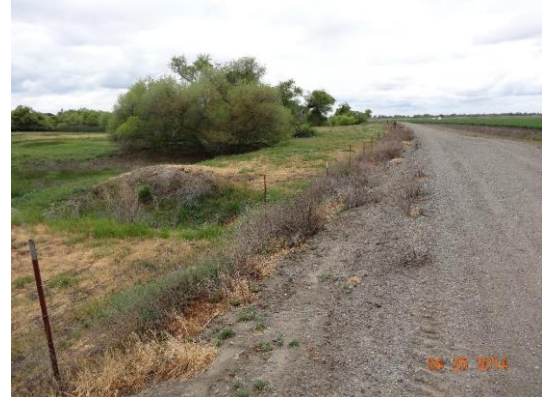
Photo 1 of 3 : UCIP\_SP\_2018\_39272\_65697.jpg

Comment Code						
Inspector Comment						
FS_ID:39272						
DS_ID:19604						
EP_NO: N/A						
Repair Type: Non-Urgent						
Crossing Status: Found						
UCIP Comments: Non-functional crossing-landward side is buried.						
Need to contact owner to determine status of crossing. If crossing is no longer used need to coordinate with CVFPB for proper abandonment.						
FIELD_STRUCT_DESC: 24-inch corrugated metal gravity drainage pipe through the levee, 9 feet below the crown. Flap gate on the waterside (WS) end. Brass cap No. 40 bench mark (BM) on the headwall on the landside (LS). [Additional Reference(s): DWR Levee Log, 2002. USACE San Joaquin O&M Manual 601.1, 1967, (HLM 21.76)].						
FS Date: 4/25/2014

View of waterward side.

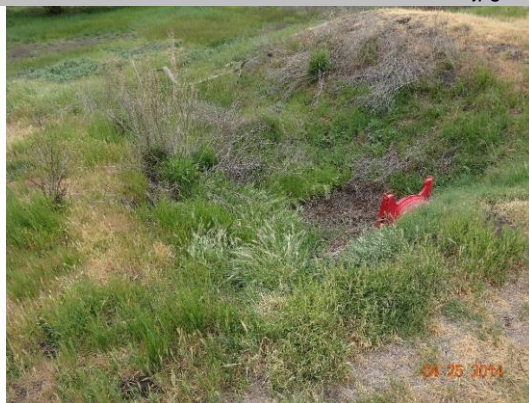
Photo 2 of 3 : UCIP\_SP\_2018\_39272\_65695.jpg

Item	DWR UCIP LMA Responsibility			37.176106 °	37.176106 °	
				-120.756768 °	-120.756768 °	
DWR ID						
Comment Code						
Inspector Comment						
FS_ID:39272						
DS_ID:19604						
EP_NO: N/A						
Repair Type: Non-Urgent						
Crossing Status: Found						
UCIP Comments: Non-functional crossing-landward side is buried.						
Need to contact owner to determine status of crossing. If crossing is no						
longer used need to coordinate with CVFPB for proper abandonment.						
FIELD_STRUCT_DESC: 24-inch corrugated metal gravity drainage pipe						
through the levee, 9 feet below the crown. Flap gate on the waterside						
(WS) end. Brass cap No. 40 bench mark (BM) on the headwall on the						
landside (LS). [Additional Reference(s): DWR Levee Log, 2002. USACE						
San Joaquin O&M Manual 601.1, 1967, (HLM 21.76)].						
FS Date: 4/25/2014

Flap gate visible on waterward side.

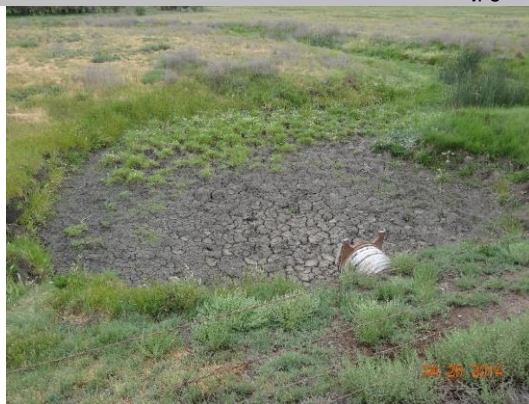
Photo 2 of 3 : UCIP\_SP\_2018\_39273\_65707.jpg

FS\_ID:39273  
DS\_ID:19605  
EP\_NO: N/A  
Repair Type: Non-Urgent  
Crossing Status: Found  
UCIP Comments: Non-functional crossing--landward side is buried.  
Need to contact owner to determine status. If crossing is no longer used need to coordinate with CVFPB for proper abandonment.  
FIELD\_STRUCT\_DESC: 24-inch corrugated metal gravity drainage pipe through the levee, 9 feet below the crown. Flap gate on the waterside (WS) end. Wooden headboards on the landside (LS) end. Brass cap No. 31 bench mark (BM) on the headwall on the LS. [Additional Reference(s): DWR Levee Log, 2002. USACE San Joaquin O&M Manual 601.1, 1967, (HLM 22.13)].  
FS Date: 4/25/2014

Flap gate visible on waterward side.

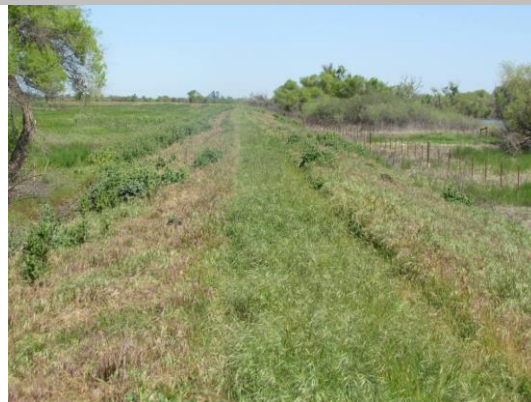
Photo 1 of 1 : SP\_2018\_NA0010\_119\_23\_20180307\_00011.jpg

LM Start	0.00	Rating **	U	Issue No.	23
LM End	1.02	Issue Type +	Ma	Location *	CR
Category	Earthen Levee			GPS Latitude/Longitude	
				Start	End
Item	Vegetation			37.296270 °	37.284950 °
				-120.880690 °	-120.871212 °
DWR ID	DWR_NA0010_02A_s_2017_23				
Comment Code					
V9 : Keep the crown roadway free of vegetation.					
Inspector Comment					
Control veg on levee crown and add additional base on levee crown.

Looking downstream at overgrown levee crown.

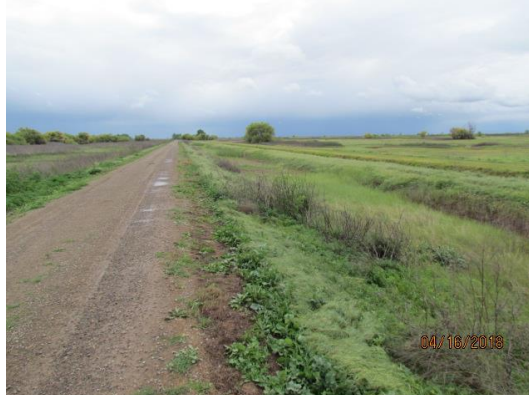
Photo 1 of 1 : SP\_2018\_NA0010\_119\_29\_20180419\_00072.jpg

LM Start	0.00	Rating **	M	Issue No.	29	
LM End	7.87	Issue Type +	Ma	Location *	LS	
Category	Earthen Levee			GPS Latitude/Longitude		
				Start		End
Item	Vegetation			37.296280 °		37.231283 °
				-120.880669 °		-120.811884 °
DWR ID	DWR_NA0010_02A_s_2018_29					
Comment Code						
V1 : Control annual grass and weeds on the levee slopes and easements.						
Inspector Comment

Looking south at typical view of landward slope. (Spring 2018)

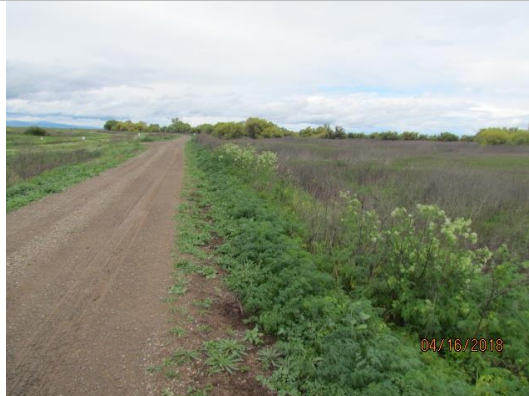
Photo 1 of 1 : SP\_2018\_NA0010\_119\_30\_20180419\_00073.jpg

LM Start	0.00	Rating **	M	Issue No.	30
LM End	7.87	Issue Type +	Ma	Location *	WS
Category	Earthen Levee			GPS Latitude/Longitude	
				Start	End
Item	Vegetation			37.296279 °	37.231282 °
				-120.880669 °	-120.811884 °
DWR ID	DWR_NA0010_02A_s_2018_30				
Comment Code					
V1 : Control annual grass and weeds on the levee slopes and easements.					
Inspector Comment

Looking north at typical view of waterward slope. (Spring 2018)

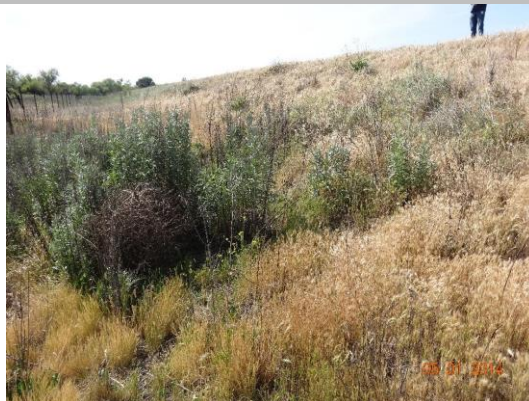
Photo 1 of 3 : UCIP\_SP\_2018\_36503\_66102.jpg

FS\_ID:36503  
DS\_ID:19652  
EP\_NO: N/A  
Repair Type: Non-Urgent  
Crossing Status: Found  
UCIP Comments: Dense vegetation limits the inspector's visibility to identify signs of pipe failure (leaks) along the slope. Recommend removing vegetation along pipe alignment to conduct proper inspection of structure.  
FIELD\_STRUCT\_DESC: 24-inch corrugated metal gravity drainage pipe through the levee, 11 feet below the crown. Flap gate on the waterside (WS) end. Brass cap No. 139 bench mark (BM) on the headwall on the landside (LS). [Additional Reference(s): DWR Levee Log, 2002. USACE San Joaquin O&M Manual 601.1, 1967, (HLM 0.24)].  
FS Date: 5/1/2014

View of waterward side.

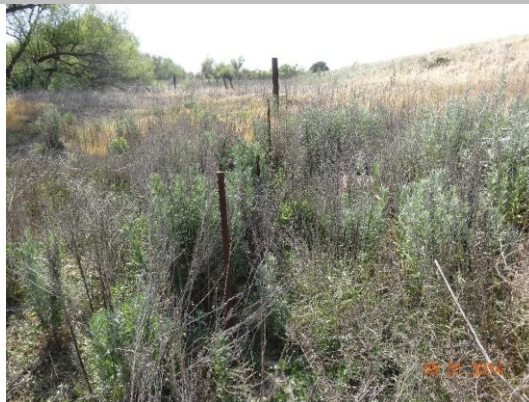
Photo 2 of 3 : UCIP\_SP\_2018\_36503\_66101.jpg

Fence along waterward side. No headwall was found on waterward side.

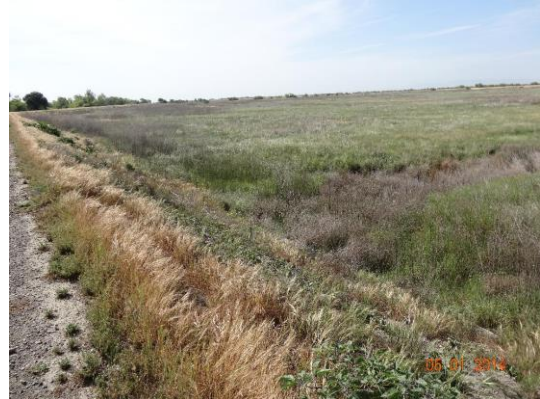
Photo 3 of 3 : UCIP\_SP\_2018\_36503\_66100.jpg

Comment Code						
Inspector Comment						
FS_ID:36503 DS_ID:19652 EP_NO: N/A Repair Type: Non-Urgent Crossing Status: Found UCIP Comments: Dense vegetation limits the inspector's visibility to identify signs of pipe failure (leaks) along the slope. Recommend removing vegetation along pipe alignment to conduct proper inspection of structure. FIELD_STRUCT_DESC: 24-inch corrugated metal gravity drainage pipe through the levee, 11 feet below the crown. Flap gate on the waterside (WS) end. Brass cap No. 139 bench mark (BM) on the headwall on the landside (LS). [Additional Reference(s): DWR Levee Log, 2002. USACE San Joaquin O&M Manual 601.1, 1967, (HLM 0.24)]. FS Date: 5/1/2014

View of landward side.

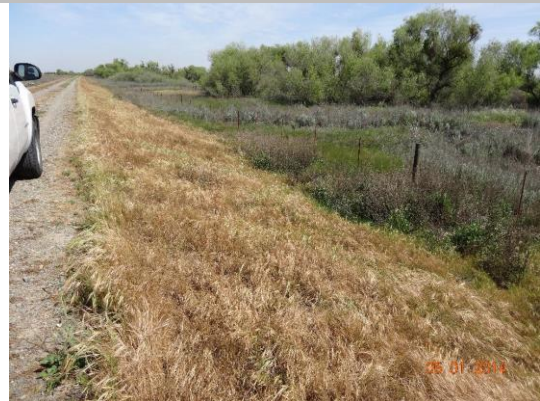
Photo 1 of 3 : UCIP\_SP\_2018\_36504\_66106.jpg

Comment Code					
Inspector Comment					
FS_ID:36504 DS_ID:19653 EP_NO: N/A Repair Type: Non-Urgent Crossing Status: Found UCIP Comments: Dense vegetation limits the inspector's visibility to identify signs of pipe failure (leaks) along the slope. Recommend removing vegetation along pipe alignment to conduct proper inspection of structure. FIELD_STRUCT_DESC: 24-inch corrugated metal gravity drainage pipe through the levee, 14.8 feet below the crown. Flap gate on the waterside (WS) end. Brass cap No. 138 bench mark (BM) on the headwall on the landside (LS). [Additional Reference(s): DWR Levee Log, 2002. USACE San Joaquin O&M Manual 601.1, 1967, (HLM 0.67)]. FS Date: 5/1/2014

View of waterward side.

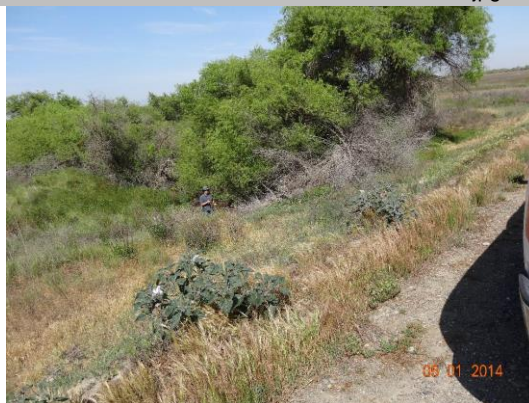
Photo 2 of 3 : UCIP\_SP\_2018\_36504\_66105.jpg

FS\_ID:36504  
DS\_ID:19653  
EP\_NO: N/A  
Repair Type: Non-Urgent  
Crossing Status: Found  
UCIP Comments: Dense vegetation limits the inspector's visibility to identify signs of pipe failure (leaks) along the slope. Recommend removing vegetation along pipe alignment to conduct proper inspection of structure.  
FIELD\_STRUCT\_DESC: 24-inch corrugated metal gravity drainage pipe through the levee, 14.8 feet below the crown. Flap gate on the waterside (WS) end. Brass cap No. 138 bench mark (BM) on the headwall on the landside (LS). [Additional Reference(s): DWR Levee Log, 2002. USACE San Joaquin O&M Manual 601.1, 1967, (HLM 0.67)].  
FS Date: 5/1/2014

View of landward side.

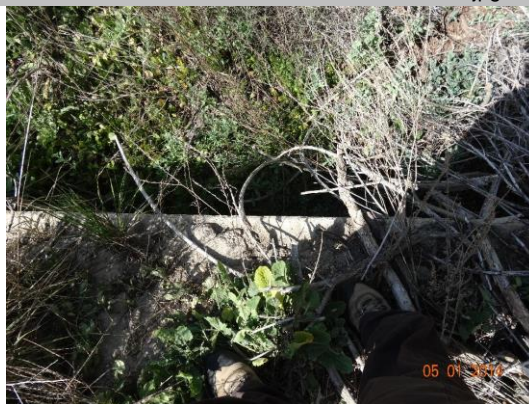
Photo 3 of 3 : UCIP\_SP\_2018\_36504\_66104.jpg

Concrete headwall found on landward side.

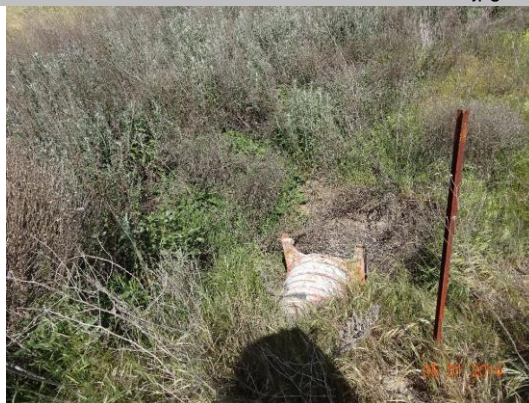
Photo 2 of 3 : UCIP\_SP\_2018\_39363\_66112.jpg

FS\_ID:39363  
DS\_ID:19654  
EP\_NO: N/A  
Repair Type: Non-Urgent  
Crossing Status: Found  
UCIP Comments: Dense vegetation limits the inspector's visibility to identify signs of pipe failure (leaks) along the slope. Recommend removing vegetation along pipe alignment to conduct proper inspection of structure. Sediment buildup in pipe recommend clearing.  
FIELD\_STRUCT\_DESC: 24-inch corrugated metal gravity drainage pipe through the levee, 8.6 feet below the crown. Flap gate on the waterside (WS) end. Brass cap No. 137 bench mark (BM) on the headwall on the landside (LS). [Additional Reference(s): DWR Levee Log, 2002. USACE San Joaquin O&M Manual 601.1, 1967, (HLM 1.02)].  
FS Date: 5/1/2014

Pipe visible on waterward side.

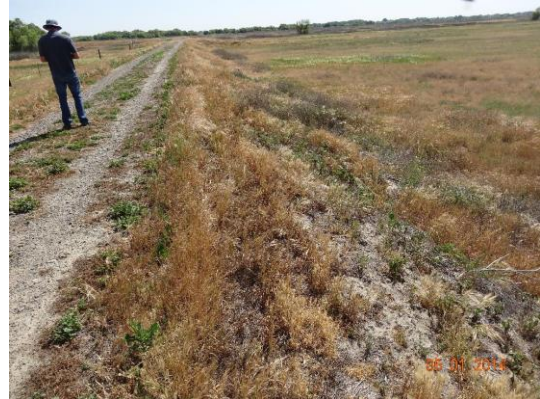
Photo 3 of 3 : UCIP\_SP\_2018\_36506\_66116.jpg

FS\_ID:36506  
DS\_ID:19655  
EP\_NO: N/A  
Repair Type: Non-Urgent  
Crossing Status: Found  
UCIP Comments: Dense vegetation limits the inspector's visibility to identify signs of pipe failure (leaks) along the slope. Recommend removing vegetation along pipe alignment to conduct proper inspection of structure.  
FIELD\_STRUCT\_DESC: 24-inch corrugated metal gravity drainage pipe through the levee, 8.6 feet below the crown. Flap gate on the waterside (WS) end. Brass cap No. 136 bench mark (BM) on the headwall on the landside (LS). [Additional Reference(s): DWR Levee Log, 2002. USACE San Joaquin O&M Manual 601.1, 1967, (HLM 1.22)].  
FS Date: 5/1/2014

View of landward side.

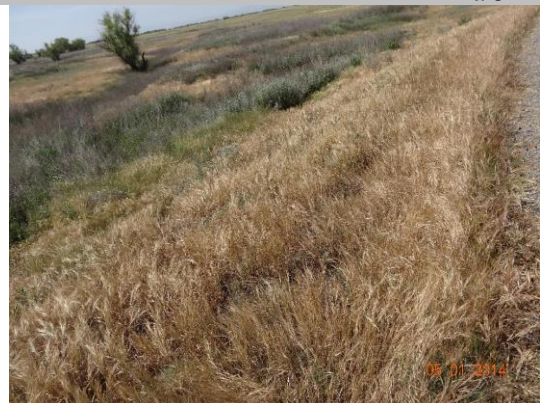
Photo 1 of 3 : UCIP\_SP\_2018\_36507\_66120.jpg

FS\_ID:36507  
DS\_ID:19656  
EP\_NO: N/A  
Repair Type: Non-Urgent  
Crossing Status: Found  
UCIP Comments: Dense vegetation limits the inspector's visibility to identify signs of pipe failure (leaks) along the slope. Recommend removing vegetation along pipe alignment to conduct proper inspection of structure.  
FIELD\_STRUCT\_DESC: 36-inch corrugated metal gravity drainage pipe through the levee, 14.6 feet below the crown. Flap gate on the waterside (WS) end. Brass cap No. 135 bench mark (BM) on the headwall on the landside (LS). [Additional Reference(s): DWR Levee Log, 2002. USACE San Joaquin O&M Manual 601.1, 1967, (HLM 1.34)].  
FS Date: 5/1/2014

View of landward side.

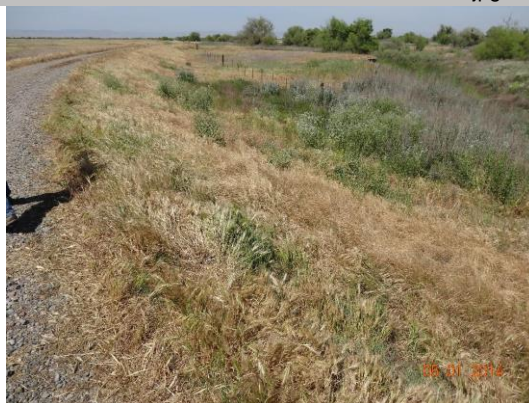
Photo 2 of 3 : UCIP\_SP\_2018\_36507\_66119.jpg

FS\_ID:36507  
DS\_ID:19656  
EP\_NO: N/A  
Repair Type: Non-Urgent  
Crossing Status: Found  
UCIP Comments: Dense vegetation limits the inspector's visibility to identify signs of pipe failure (leaks) along the slope. Recommend removing vegetation along pipe alignment to conduct proper inspection of structure.  
FIELD\_STRUCT\_DESC: 36-inch corrugated metal gravity drainage pipe through the levee, 14.6 feet below the crown. Flap gate on the waterside (WS) end. Brass cap No. 135 bench mark (BM) on the headwall on the landside (LS). [Additional Reference(s): DWR Levee Log, 2002. USACE San Joaquin O&M Manual 601.1, 1967, (HLM 1.34)].  
FS Date: 5/1/2014

View of waterward side.

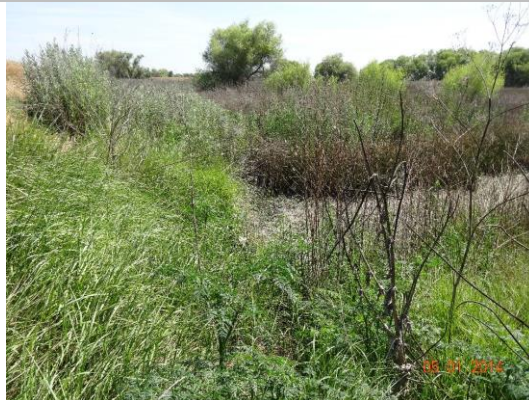
Photo 2 of 3 : UCIP\_SP\_2018\_36508\_66123.jpg

Dense vegetation along levee slope and toe.

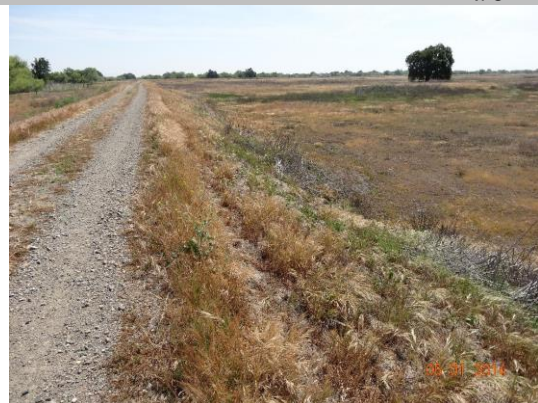
Photo 1 of 3 : UCIP\_SP\_2018\_36509\_66129.jpg

FS\_ID:36509  
DS\_ID:19658  
EP\_NO: N/A  
Repair Type: Non-Urgent  
Crossing Status: Found  
UCIP Comments: Dense vegetation limits the inspector's visibility to identify signs of pipe failure (leaks) along the slope. Recommend removing vegetation along pipe alignment to conduct proper inspection of structure.  
FIELD\_STRUCT\_DESC: 24-inch corrugated metal gravity drainage pipe through the levee, 10.7 feet below the crown. Flap gate on the waterside (WS) end. Brass cap No. 135 bench mark (BM) on the headwall on the landside (LS). [Additional Reference(s): DWR Levee Log, 2002. USACE San Joaquin O&M Manual 601.1, 1967, (HLM 1.86)].  
FS Date: 5/1/2014

View of landward side.

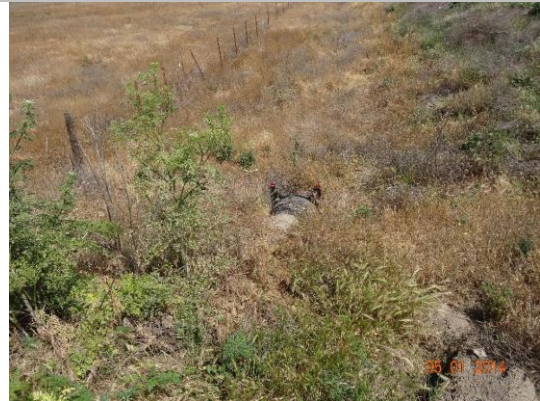
Photo 3 of 3 : UCIP\_SP\_2018\_36510\_66131.jpg

View of pipe through levee visible on waterward side.

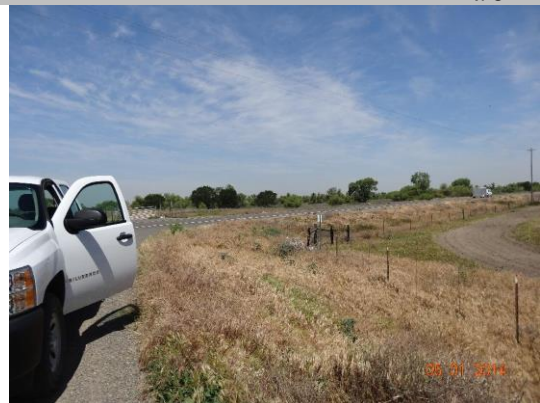
Photo 1 of 3 : UCIP\_SP\_2018\_36511\_66137.jpg

Comment Code						
Inspector Comment						
FS_ID:36511						
DS_ID:19660						
EP_NO: N/A						
Repair Type: Non-Urgent						
Crossing Status: Found						
UCIP Comments: Dense vegetation limits the inspector's visibility to identify signs of pipe failure (leaks) along the slope. Recommend removing vegetation along pipe alignment to conduct proper inspection of structure.						
FIELD_STRUCT_DESC: 24-inch corrugated metal gravity drainage pipe through the levee, 7 feet below the crown. Flap gate on the waterside (WS) end. Brass cap No. 135 bench mark (BM) on the headwall on the landside (LS). [Additional Reference(s): DWR Levee Log, 2002. USACE San Joaquin O&M Manual 601.1, 1967, (HLM 2.32)].						
FS Date: 5/1/2014

View of waterward side.

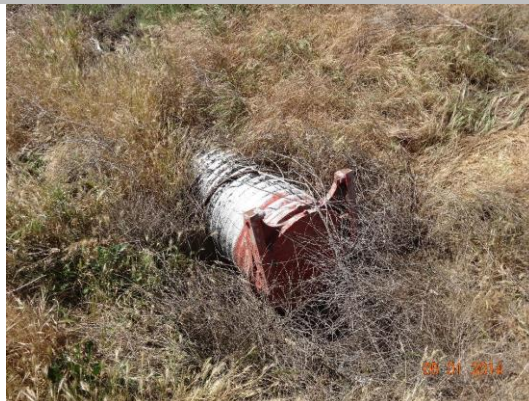
Photo 2 of 3 : UCIP\_SP\_2018\_36511\_66136.jpg

Flap gate visible on waterward side.

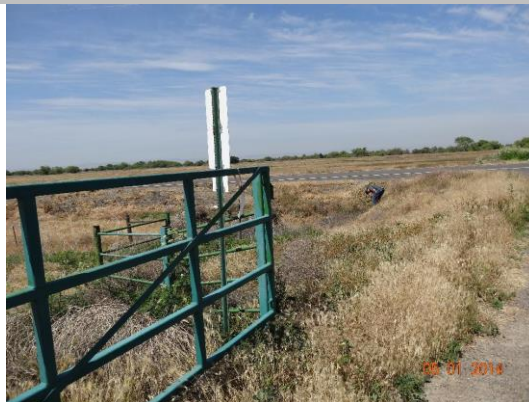
Photo 3 of 3 : UCIP\_SP\_2018\_36511\_66138.jpg

Overview of landward slope.

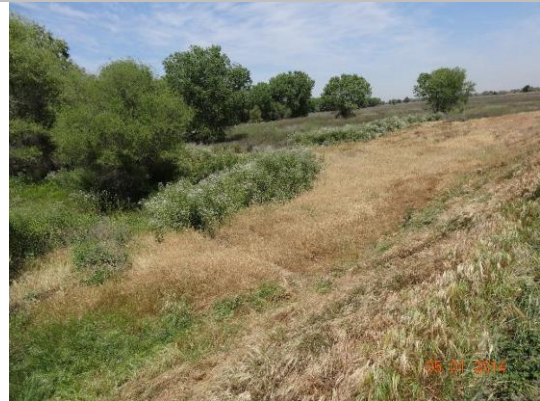
Photo 3 of 3 : UCIP\_SP\_2018\_36514\_66152.jpg

View of landward side.

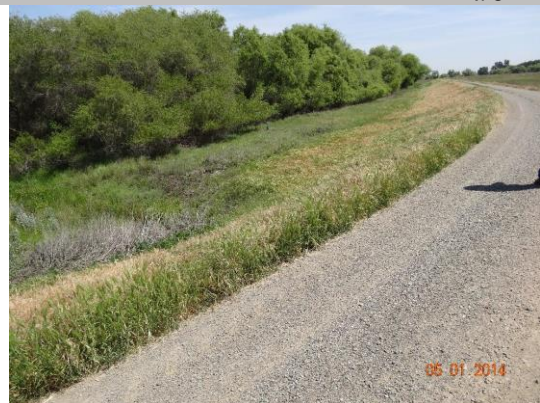
Photo 1 of 3 : UCIP\_SP\_2018\_36515\_66155.jpg

Comment Code						
Inspector Comment						
FS_ID:36515						
DS_ID:19666						
EP_NO: N/A						
Repair Type: Non-Urgent						
Crossing Status: Found						
UCIP Comments: Dense vegetation limits the inspector's visibility to identify signs of pipe failure (leaks) along the slope. Recommend removing vegetation along pipe alignment to conduct proper inspection of structure.						
FIELD_STRUCT_DESC: 24-inch corrugated metal gravity drainage pipe through the levee, 10 feet below the crown. Flap gate on the waterside (WS) end. Brass cap No. 130 bench mark (BM) on the headwall on the landside (LS). [Additional Reference(s): DWR Levee Log, 2002. USACE San Joaquin O&M Manual 601.1, 1967, (HLM 3.62)].						
FS Date: 5/1/2014

View of waterward side.

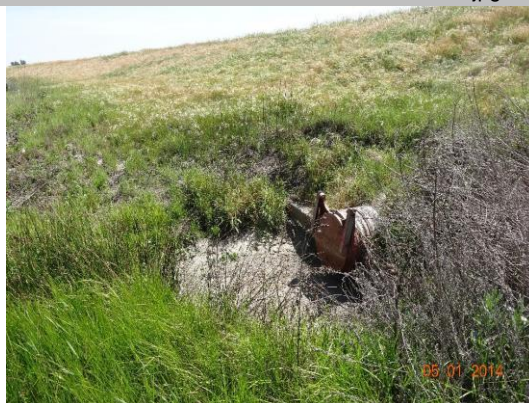
Photo 2 of 3 : UCIP\_SP\_2018\_36515\_66154.jpg

Flap gate visible on waterward side.

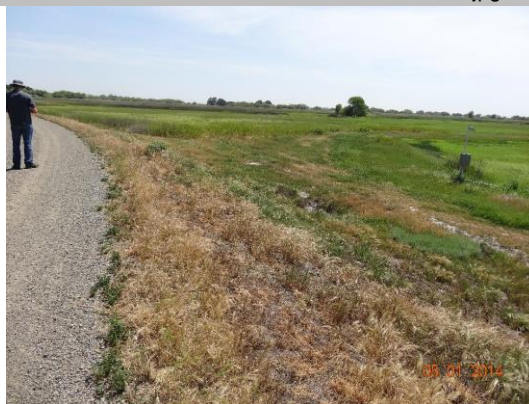
Photo 3 of 3 : UCIP\_SP\_2018\_36515\_66156.jpg

View of landward side.

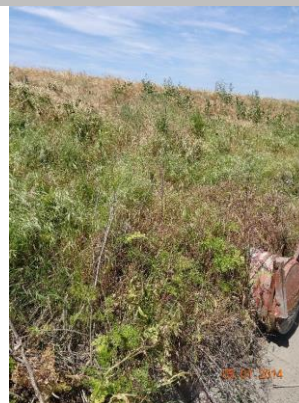
Photo 3 of 3 : UCIP\_SP\_2018\_36517\_66165.jpg

Comment Code						
Inspector Comment						
FS_ID:36517 DS_ID:19668 EP_NO: N/A Repair Type: Non-Urgent Crossing Status: Found UCIP Comments: Dense vegetation limits the inspector's visibility to identify signs of pipe failure (leaks) along the slope. Recommend removing vegetation along pipe alignment to conduct proper inspection of structure. FIELD_STRUCT_DESC: 24-inch corrugated metal gravity drainage pipe through the levee, 8 feet below the crown. Flap gate on the waterside (WS) end. Brass cap No. 125 bench mark (BM) on the headwall on the landside (LS). [Additional Reference(s): DWR Levee Log, 2002. USACE San Joaquin O&M Manual 601.1, 1967, (HLM 5.43)]. FS Date: 5/1/2014

View of waterward slope covered by vegetation.

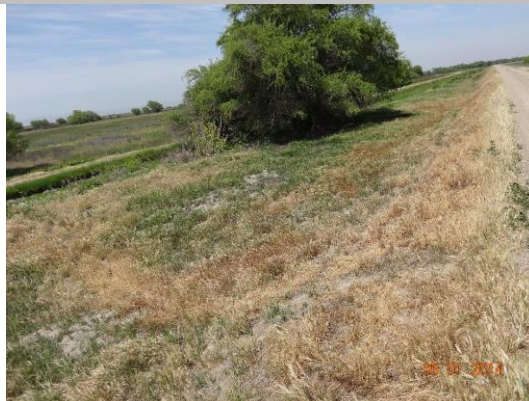
Photo 1 of 2 : UCIP\_SP\_2018\_36518\_66171.jpg

FS\_ID:36518  
DS\_ID:19669  
EP\_NO: N/A  
Repair Type: Non-Urgent  
Crossing Status: Found  
UCIP Comments: Dense vegetation limits the inspector's visibility to identify signs of pipe failure (leaks) along the slope. Recommend removing vegetation along pipe alignment to conduct proper inspection of structure.  
FIELD\_STRUCT\_DESC: 24-inch corrugated metal gravity drainage pipe through the levee, 7.7 feet below the crown. Flap gate on the waterside (WS) end. Brass cap No. 125 bench mark (BM) on the headwall on the landside (LS). [Additional Reference(s): DWR Levee Log, 2002. USACE San Joaquin O&M Manual 601.1, 1967, (HLM 6.06)].  
FS Date: 5/1/2014

View of landward side.

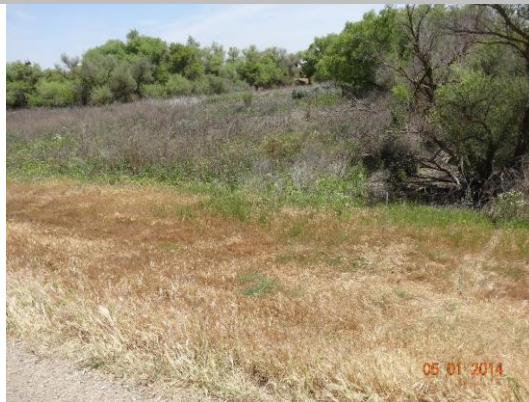
Photo 2 of 2 : UCIP\_SP\_2018\_36518\_66170.jpg

View of waterward side.

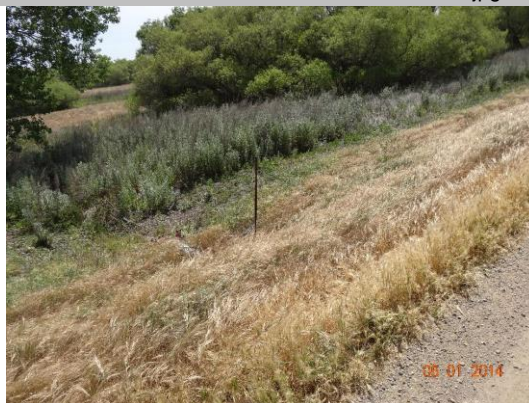
Photo 1 of 3 : UCIP\_SP\_2018\_36519\_66173.jpg

FS\_ID:36519  
DS\_ID:19670  
EP\_NO: N/A  
Repair Type: Non-Urgent  
Crossing Status: Found  
UCIP Comments: Dense vegetation limits the inspector's visibility to identify signs of pipe failure (leaks) along the slope. Recommend removing vegetation along pipe alignment to conduct proper inspection of structure.  
FIELD\_STRUCT\_DESC: 24-inch corrugated metal gravity drainage pipe through the levee, 7.7 feet below the crown. Flap gate on the waterside (WS) end. Brass cap No. 125 bench mark (BM) on the headwall on the landside (LS). [Additional Reference(s): DWR Levee Log, 2002. USACE San Joaquin O&M Manual 601.1, 1967, (HLM 6.50)].  
FS Date: 5/1/2014

View of waterward side.

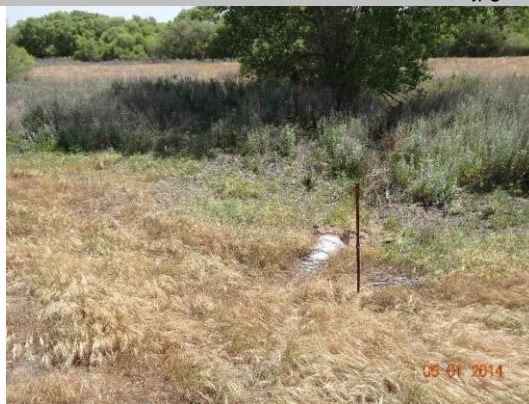
Photo 2 of 3 : UCIP\_SP\_2018\_36519\_66172.jpg

Crossing and flap gate visible on waterward side.

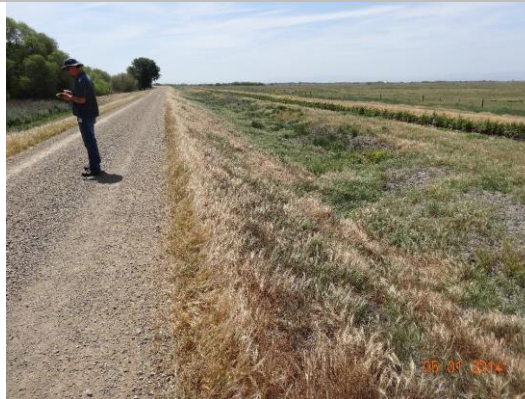
Photo 3 of 3 : UCIP\_SP\_2018\_36519\_66174.jpg

Comment Code						
Inspector Comment						
FS_ID:36519 DS_ID:19670 EP_NO: N/A Repair Type: Non-Urgent Crossing Status: Found UCIP Comments: Dense vegetation limits the inspector's visibility to identify signs of pipe failure (leaks) along the slope. Recommend removing vegetation along pipe alignment to conduct proper inspection of structure. FIELD_STRUCT_DESC: 24-inch corrugated metal gravity drainage pipe through the levee, 7.7 feet below the crown. Flap gate on the waterside (WS) end. Brass cap No. 125 bench mark (BM) on the headwall on the landside (LS). [Additional Reference(s): DWR Levee Log, 2002. USACE San Joaquin O&M Manual 601.1, 1967, (HLM 6.50)]. FS Date: 5/1/2014

Overview of levee crown and landward slope.

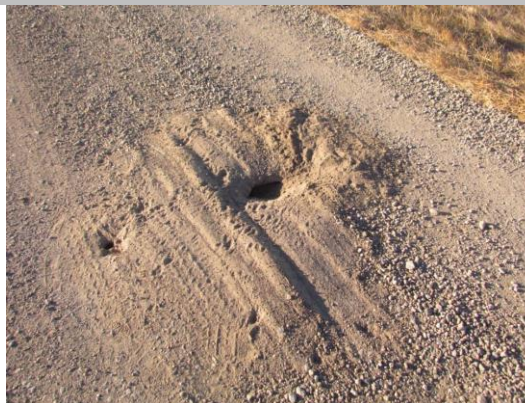
Photo 1 of 2 : SP\_2018\_NA0010\_119\_22\_20180307\_00009.jpg

LM Start	6.85	Rating **	M	Issue No.	22
LM End	6.85	Issue Type +	Ma	Location *	CR
Category	Earthen Levee			GPS Latitude/Longitude	
				Start	End
Item	Animal Control			37.242833 °	37.242833 °
				-120.822270 °	-120.822270 °
DWR ID	DWR_NA0010_02A_f_2016_22				
Comment Code					
A1 : Exterminate rodents and backfill and compact or grout burrows.					
Inspector Comment					
Noticed several burrow holes on the levee crown. It does not seem to be rodent holes or gopher holes. It could be moles.

Looking at rodent hole on levee crown.

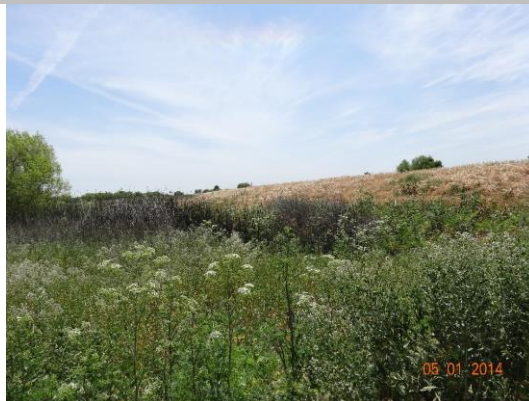
Photo 3 of 3 : UCIP\_SP\_2018\_36521\_66181.jpg

Comment Code						
Inspector Comment						
FS_ID:36521 DS_ID:19673 EP_NO: N/A Repair Type: Non-Urgent Crossing Status: Found UCIP Comments: Dense vegetation limits the inspector's visibility to identify signs of pipe failure (leaks) along the slope. Recommend removing vegetation along pipe alignment to conduct proper inspection of structure. FIELD_STRUCT_DESC: 24-inch corrugated metal gravity drainage pipe through the levee, 8 feet below the crown. Flap gate on the waterside (WS) end. Brass cap No. 125 bench mark (BM) on the headwall on the landside (LS). [Additional Reference(s): DWR Levee Log, 2002. USACE San Joaquin O&M Manual 601.1, 1967, (HLM 7.77)]. FS Date: 5/1/2014

View of waterward side--photo taken from levee toe looking towards alignment of crossing.

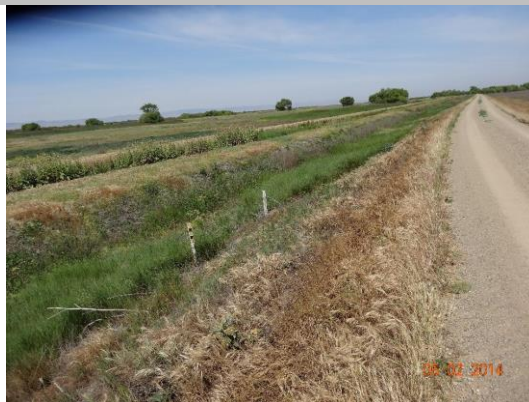
Photo 1 of 3 : UCIP\_SP\_2018\_39366\_66184.jpg

Comment Code					
Inspector Comment					
FS_ID:39366 DS_ID:19674 EP_NO: N/A Repair Type: Non-Urgent Crossing Status: Found UCIP Comments: Dense vegetation limits the inspector's visibility to identify signs of pipe failure (leaks) along the slope and landward headwall. Recommend removing vegetation along pipe alignment and toe to conduct proper inspection of structure. Sediment buildup in pipe visible from landward side--recommend clearing. FIELD_STRUCT_DESC: 24-inch corrugated metal gravity drainage pipe through the levee, 9 feet below the crown. Flap gate on the waterside (WS) end. Brass cap No. 120 bench mark (BM) on the headwall on the landside (LS). [Additional Reference(s): DWR Levee Log, 2002. USACE San Joaquin O&M Manual 601.1, 1967, (HLM 8.16)]. FS Date: 5/14/2014

View of landward side.

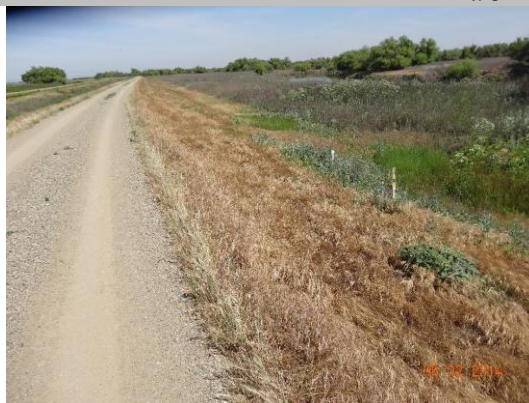
Photo 3 of 3 : UCIP\_SP\_2018\_39366\_66186.jpg

View of waterward side.
