**Flood Control Project Maintenance  
Levee Inspections**

## Maintenance Issue Types Only, Levee Inspection Report By Mile - Spring 2018

### Lower San Joaquin Levee District

Waterway	Bank	Unit Miles	Inspection Start/End	Inspector
Unit No. 01 San Joaquin River	Right	22.52	04/04/2018 04/16/2018	Richard Willoughby

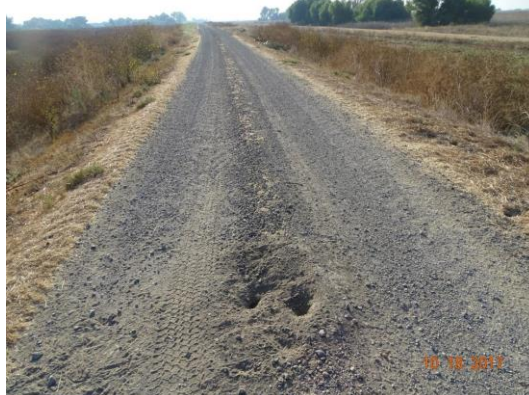
Photo 1 of 1 : SP\_2018\_NA0010\_120\_15\_20180307\_00004.jpg

LM Start	8.14	Rating **	M	Issue No.	15
LM End	8.14	Issue Type +	Ma	Location *	CR
Category	Earthen Levee			GPS Latitude/Longitude	
				Start	End
Item	Animal Control			37.228224 °	37.228224 °
				-120.808622 °	-120.808622 °
DWR ID	DWR_NA0010_02B_f_2017_15				
Comment Code					
A3 : No rodents visible, but rodent burrows visible; need to backfill and compact or grout burrows.					
Inspector Comment					
Several rodent holes on the crown.

Looking southeast at the crown.

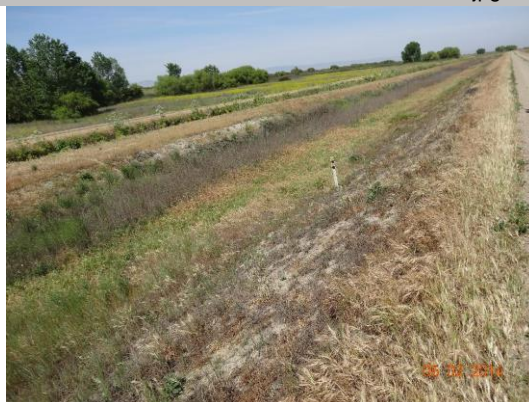
Photo 1 of 3 : UCIP\_SP\_2018\_39367\_66195.jpg

FS\_ID:39367  
DS\_ID:19675  
EP\_NO: N/A  
Repair Type: Non-Urgent  
Crossing Status: Found  
UCIP Comments: Dense vegetation on landward toe. Also dense vegetation limits the inspector's visibility to identify signs of pipe failure (leaks) along waterward slope. Recommend removing vegetation along pipe alignment toe to conduct proper inspection of structure. Sediment buildup in pipe--recommend clearing.  
FIELD\_STRUCT\_DESC: 24-inch corrugated metal gravity drainage pipe through the levee, 9.4 feet below the crown. Flap gate on the waterside (WS) end. Brass cap No. 120 bench mark (BM) on the headwall on the landside (LS). [Additional Reference(s): DWR Levee Log, 2002. USACE San Joaquin O&M Manual 601.1, 1967, (HLM 8.48)].  
FS Date: 5/14/2014

View of landward side.

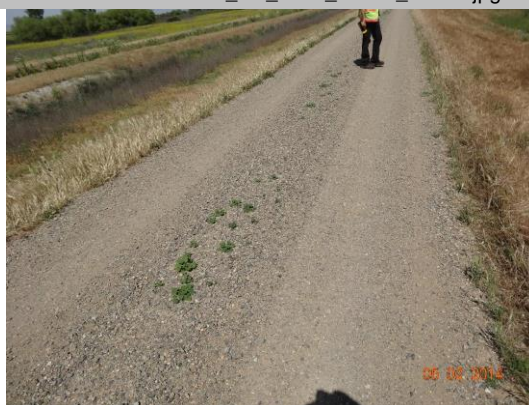
Photo 2 of 3 : UCIP\_SP\_2018\_39367\_66193.jpg

Overview of levee crown at crossing.

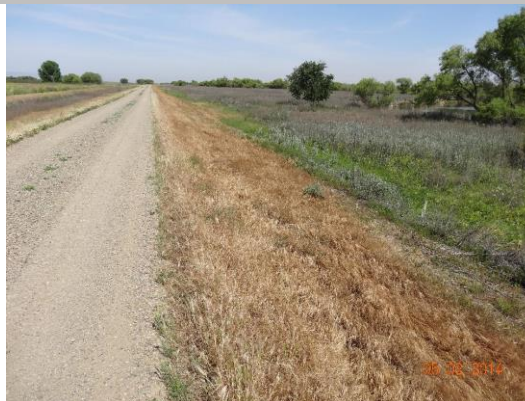
Photo 3 of 3 : UCIP\_SP\_2018\_39367\_66194.jpg

Comment Code						
Inspector Comment						
FS_ID:39367						
DS_ID:19675						
EP_NO: N/A						
Repair Type: Non-Urgent						
Crossing Status: Found						
UCIP Comments: Dense vegetation on landward toe. Also dense vegetation limits the inspector's visibility to identify signs of pipe failure (leaks) along waterward slope. Recommend removing vegetation along pipe alignment toe to conduct proper inspection of structure. Sediment buildup in pipe--recommend clearing.						
FIELD_STRUCT_DESC: 24-inch corrugated metal gravity drainage pipe through the levee, 9.4 feet below the crown. Flap gate on the waterside (WS) end. Brass cap No. 120 bench mark (BM) on the headwall on the landside (LS). [Additional Reference(s): DWR Levee Log, 2002. USACE San Joaquin O&M Manual 601.1, 1967, (HLM 8.48)].						
FS Date: 5/14/2014

View of waterward side.

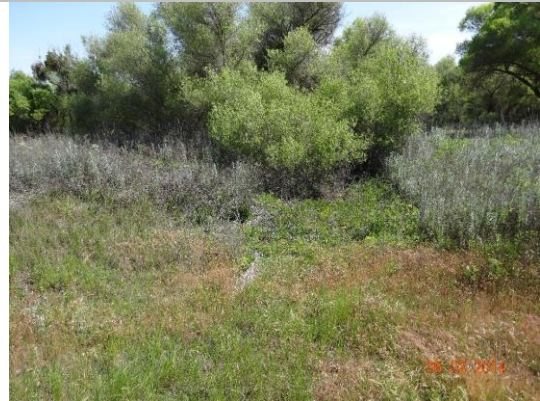
Photo 3 of 3 : UCIP\_SP\_2018\_42503\_66201.jpg

Comment Code						
Inspector Comment						
FS_ID:42503 DS_ID:19676 EP_NO: N/A Repair Type: Non-Urgent Crossing Status: Found UCIP Comments: Dense vegetation limits the inspector's visibility to identify signs of pipe failure (leaks) along the slope. Recommend removing vegetation along pipe alignment to conduct proper inspection of structure. Burrow activity presen on waterward slope. FIELD_STRUCT_DESC: 24-inch corrugated metal gravity drainage pipe through the levee, 8.8 feet below the crown. Flap gate on the waterside (WS) end. Brass cap No. 120 bench mark (BM) on the headwall on the landside (LS). [Additional Reference(s): DWR Levee Log, 2002. USACE San Joaquin O&M Manual 601.1, 1967, (HLM 8.86)]. FS Date: 5/14/2014

View of waterward toe.

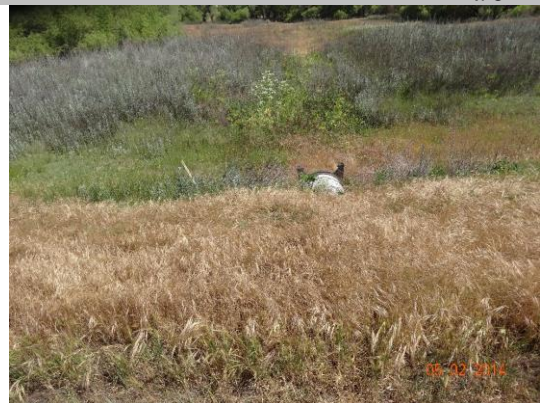
Photo 1 of 3 : UCIP\_SP\_2018\_36525\_66208.jpg

Comment Code					
Inspector Comment					
FS_ID:36525					
DS_ID:19677					
EP_NO: N/A					
Repair Type: Non-Urgent					
Crossing Status: Found					
UCIP Comments: Dense vegetation limits the inspector's visibility to identify signs of pipe failure (leaks) along the slope. Recommend removing vegetation along pipe alignment to conduct proper inspection of structure.					
FIELD_STRUCT_DESC: 36-inch corrugated metal gravity drainage pipe through the levee, 8.8 feet below the crown. Flap gate on the waterside (WS) end. Brass cap No. 120 bench mark (BM) on the headwall on the landside (LS). [Additional Reference(s): DWR Levee Log, 2002. USACE San Joaquin O&M Manual 601.1, 1967, (HLM 9.02)].					
FS Date: 5/14/2014

View of waterward side--pipe and flap gate visible.

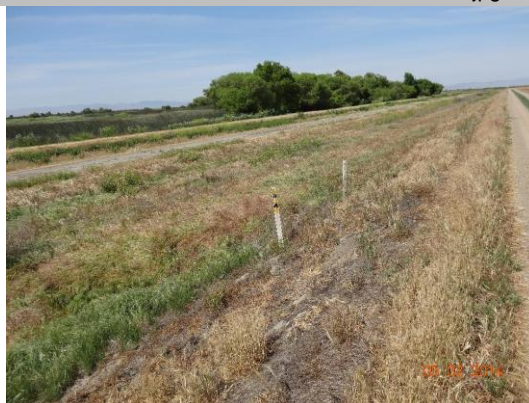
Photo 1 of 3 : UCIP\_SP\_2018\_40443\_66211.jpg

View of landward side.

Comment Code						
Inspector Comment						
FS_ID:40443 DS_ID:19678 EP_NO: N/A Repair Type: Non-Urgent Crossing Status: Found UCIP Comments: Dense vegetation limits the inspector's visibility to identify signs of pipe failure (leaks) along the slope. Recommend removing vegetation along pipe alignment to conduct proper inspection of structure. FIELD_STRUCT_DESC: 24-inch corrugated metal gravity drainage pipe through the levee, 8 feet below the crown. Flap gate on the waterside (WS) end. Brass cap No. 120 bench mark (BM) on the headwall on the landside (LS). [Additional Reference(s): DWR Levee Log, 2002. USACE San Joaquin O&M Manual 601.1, 1967, (HLM 9.20)]. FS Date: 5/14/2014

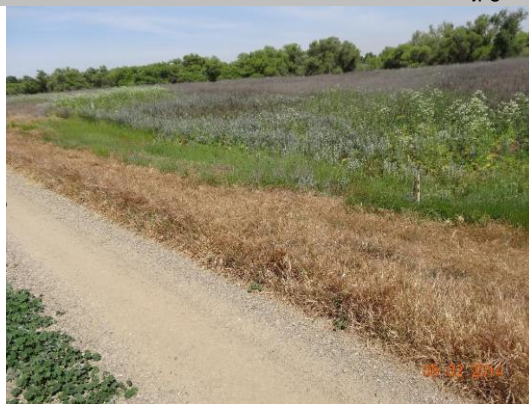
Photo 2 of 3 : UCIP\_SP\_2018\_40443\_66210.jpg

View of waterward side.

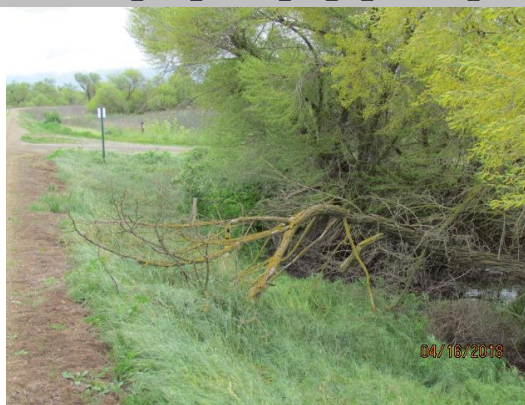
Photo 1 of 1 : SP\_2018\_NA0010\_120\_17\_20180419\_00046.jpg

LM Start	9.42	Rating **	M	Issue No.	17
LM End	9.42	Issue Type +	Ma	Location *	LS
Category	Earthen Levee			GPS Latitude/Longitude	
				Start	End
Item	Trim / Thin Trees			37.220199 °	37.220199 °
				-120.788748 °	-120.788748 °
DWR ID	DWR_NA0010_02B_f_2016_17				
Comment Code					
T1 : Trim trees to at least five feet above ground level.					
Inspector Comment					
Trim back dead tree limbs on landside toe.

Looking north at broken tree limbs and branches on landward slope.  
(Spring 2018)

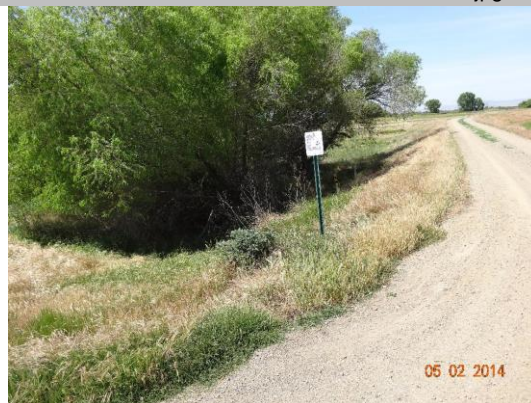
Photo 1 of 3 : UCIP\_SP\_2018\_36527\_66217.jpg

View of landward side.

Comment Code						
Inspector Comment						
FS_ID:36527 DS_ID:19686 EP_NO: N/A Repair Type: Non-Urgent Crossing Status: Found UCIP Comments: Dense vegetation limits the inspector's visibility to identify signs of pipe failure (leaks) along the slope. Recommend removing vegetation along pipe alignment to conduct proper inspection of structure. FIELD_STRUCT_DESC: 24-inch corrugated metal gravity drainage pipe through the levee, 9 feet below the crown. Flap gate on the waterside (WS) end. Brass cap No. 115 bench mark (BM) on the headwall on the landside (LS). [Additional Reference(s): DWR Levee Log, 2002. USACE San Joaquin O&M Manual 601.1, 1967, (HLM 9.46)]. FS Date: 5/14/2014

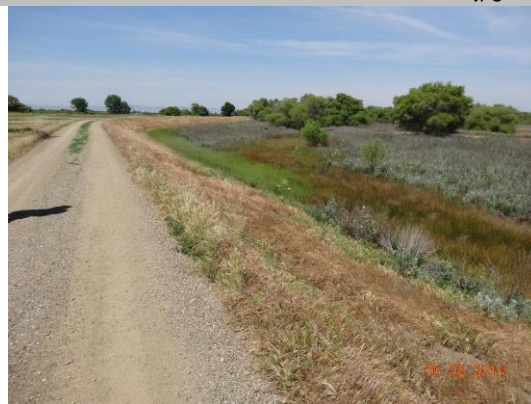
Photo 2 of 3 : UCIP\_SP\_2018\_36527\_66216.jpg

View of waterward side.

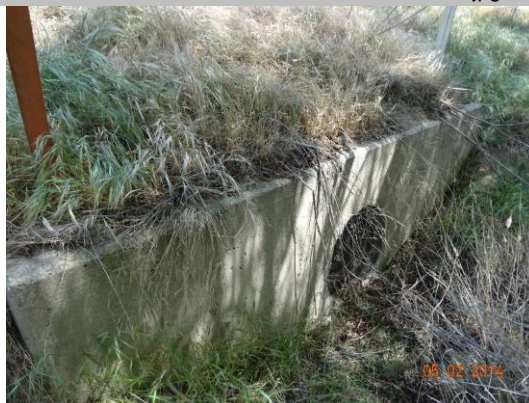
Photo 3 of 3 : UCIP\_SP\_2018\_36527\_66215.jpg

Concrete headwall visible on landward side.

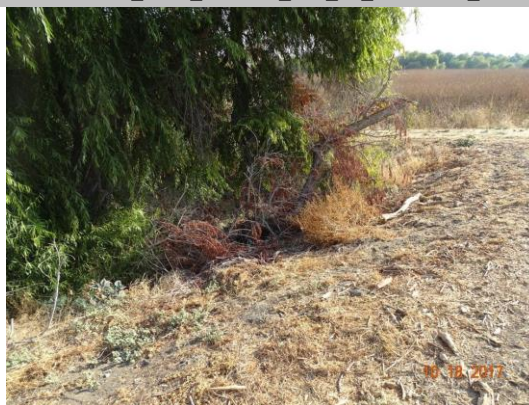
Photo 1 of 1 : SP\_2018\_NA0010\_120\_18\_20180307\_00005.jpg

LM Start	9.60	Rating **	M	Issue No.	18
LM End	9.60	Issue Type +	Ma	Location *	WS
Category	Earthen Levee			GPS Latitude/Longitude	
				Start	End
Item	Encroachments			37.220794 °	37.220794 °
				-120.785721 °	-120.785721 °
DWR ID	DWR_NA0010_02B_f_2017_18				
Comment Code					
TR : Tree or limb					
Inspector Comment

Looking southeast at waterside slope.

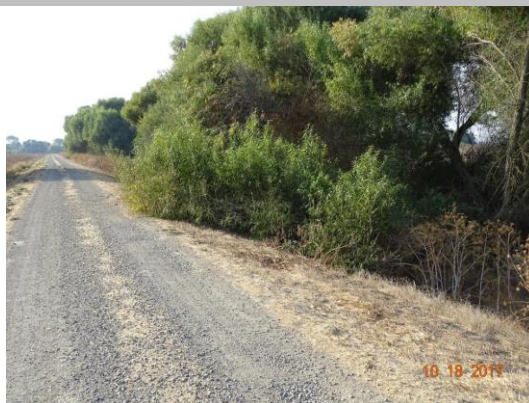
Photo 1 of 2 : SP\_2018\_NA0010\_120\_23\_20180307\_00009.jpg

LM Start	9.75	Rating **	U	Issue No.	23
LM End	9.75	Issue Type +	Ma	Location *	LS
Category	Earthen Levee			GPS Latitude/Longitude	
				Start	End
Item	Trim / Thin Trees			37.219083 °	37.219083 °
				-120.784327 °	-120.784327 °
DWR ID	DWR_NA0010_02B_s_2017_23				
Comment Code					
T1 : Trim trees to at least five feet above ground level.					
Inspector Comment

Looking south at landside slope.

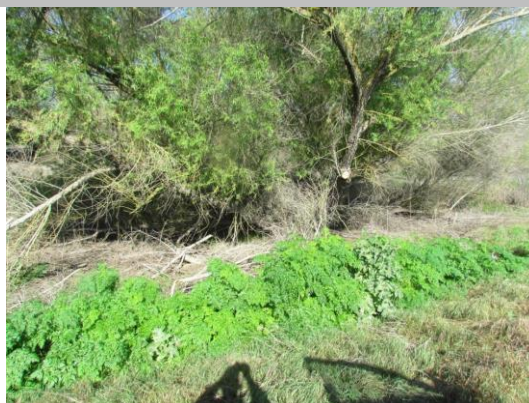
Photo 2 of 2 : SP\_2018\_NA0010\_120\_23\_20180307\_00010.jpg

Looking west at untrimmed trees at landward toe.

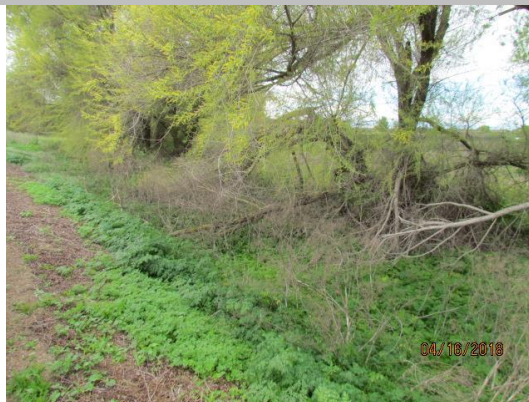
Photo 1 of 1 : SP\_2018\_NA0010\_120\_24\_20180419\_00047.jpg

LM Start	9.83	Rating **	M	Issue No.	24
LM End	9.83	Issue Type +	Ma	Location *	LS
Category	Earthen Levee			GPS Latitude/Longitude	
				Start	End
Item	Encroachments			37.218037 °	37.218037 °
				-120.784199 °	-120.784199 °
DWR ID	DWR_NA0010_02B_s_2018_24				
Comment Code					
TR : Tree or limb					
Inspector Comment					
Remove dead tree limbs and branches for landward berm.

Looking west at dead tree limbs and branches on landward slope.  
(Spring 2018)

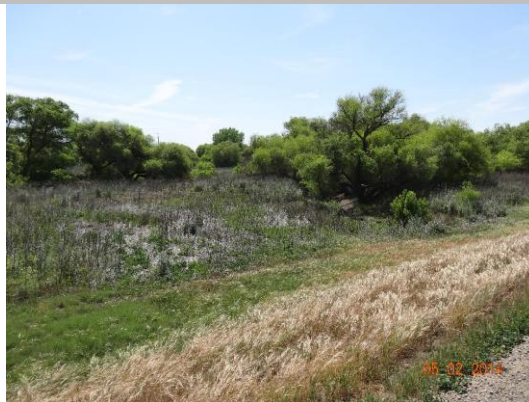
Photo 1 of 3 : UCIP\_SP\_2018\_36528\_66224.jpg

Comment Code						
Inspector Comment						
FS_ID:36528 DS_ID:19687 EP_NO: N/A Repair Type: Non-Urgent Crossing Status: Found UCIP Comments: Dense vegetation limits the inspector's visibility to identify signs of pipe failure (leaks) along the slope. Recommend removing vegetation along pipe alignment to conduct proper inspection of structure. FIELD_STRUCT_DESC: 24-inch corrugated metal gravity drainage pipe through the levee, 11.7 feet below the crown. Flap gate on the waterside (WS) end. Brass cap No. 115 bench mark (BM) on the headwall on the landside (LS). [Additional Reference(s): DWR Levee Log, 2002. USACE San Joaquin O&M Manual 601.1, 1967, (HLM 10.12)]. FS Date: 5/14/2014

Overview of waterward side.

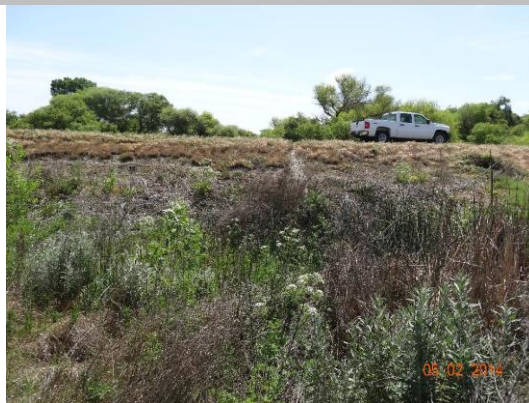
Photo 2 of 3 : UCIP\_SP\_2018\_36528\_66226.jpg

View of waterward slope.

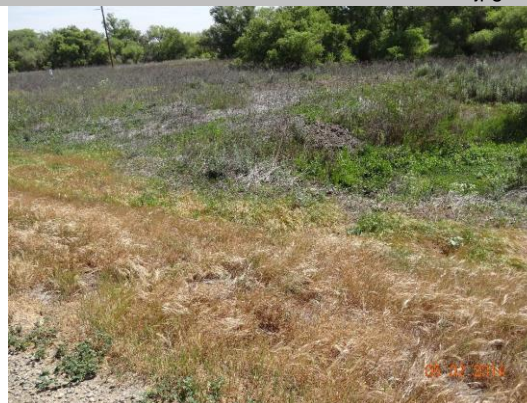
Photo 3 of 3 : UCIP\_SP\_2018\_36528\_66222.jpg

Item	DWR UCIP LMA Responsibility			37.214229 °		37.214229 °
				-120.784350 °		-120.784350 °
DWR ID						
Comment Code						
Inspector Comment						
FS_ID:36528						
DS_ID:19687						
EP_NO: N/A						
Repair Type: Non-Urgent						
Crossing Status: Found						
UCIP Comments: Dense vegetation limits the inspector's visibility to identify signs of pipe failure (leaks) along the slope. Recommend removing vegetation along pipe alignment to conduct proper inspection of structure.						
FIELD_STRUCT_DESC: 24-inch corrugated metal gravity drainage pipe through the levee, 11.7 feet below the crown. Flap gate on the waterside (WS) end. Brass cap No. 115 bench mark (BM) on the headwall on the landside (LS). [Additional Reference(s): DWR Levee Log, 2002. USACE San Joaquin O&M Manual 601.1, 1967, (HLM 10.12)].						
FS Date: 5/14/2014

View of waterward side.

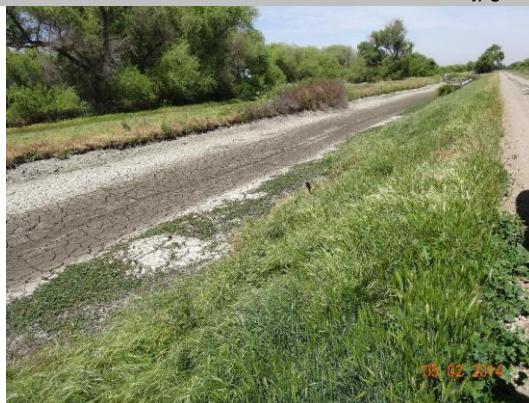
Photo 2 of 3 : UCIP\_SP\_2018\_39370\_66244.jpg

Item	DWR UCIP LMA Responsibility			37.179265 °	37.179265 °	
				-120.764870 °	-120.764870 °	
DWR ID						
Comment Code						
Inspector Comment						
FS_ID:39370 DS_ID:19663 EP_NO: N/A Repair Type: Non-Urgent Crossing Status: Found UCIP Comments: Dense vegetation limits the inspector's visibility to identify signs of pipe failure (leaks) along the slope. Recommend removing vegetation along pipe alignment to conduct proper inspection of structure. Sediment buildup in pipe--recommend clearing. FIELD_STRUCT_DESC: 24-inch corrugated metal gravity drainage pipe through the levee, 6.5 feet below the crown. Slide gate in a pipe riser on the waterside (WS) slope. [Additional Reference(s): DWR Levee Log, 2002. USACE San Joaquin O&M Manual 601.1, 1967, (HLM 13.22)]. FS Date: 5/14/2014

Overview of landward slope.

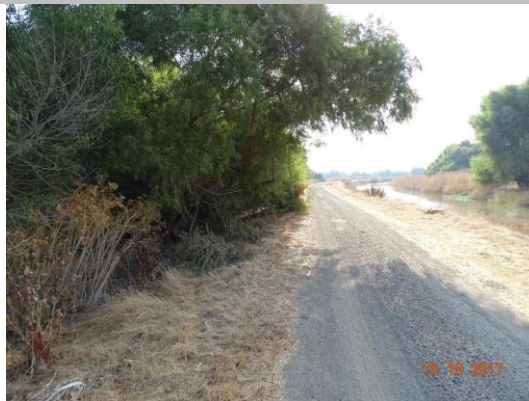
Photo 1 of 2 : SP\_2018\_NA0010\_120\_167\_20180307\_00011.jpg

LM Start	13.42	Rating **	U	Issue No.	167
LM End	13.42	Issue Type +	Ma	Location *	WS
Category	Earthen Levee			GPS Latitude/Longitude	
				Start	End
Item	Trim / Thin Trees			37.176379 °	37.176379 °
				-120.762255 °	-120.762255 °
DWR ID	DWR_NA0010_02B_s _ 2015_167				
Comment Code					
T3 : Trim and thin trees to allow visibility of the ground and room to flood fight.					
Inspector Comment					
Dense trees on waterside slope.

Looking southeast at waterside slope.

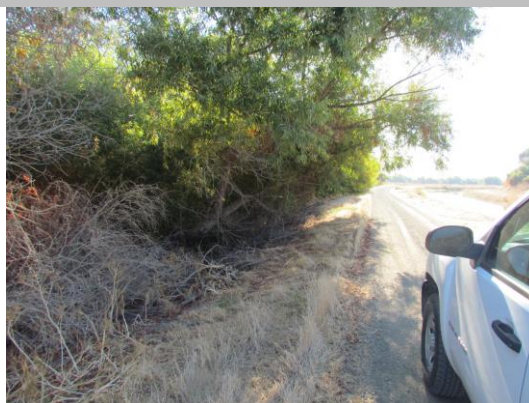
Photo 2 of 2 : SP\_2018\_NA0010\_120\_167\_20180307\_00012.jpg

Looking south at untrimmed trees on waterward slope.

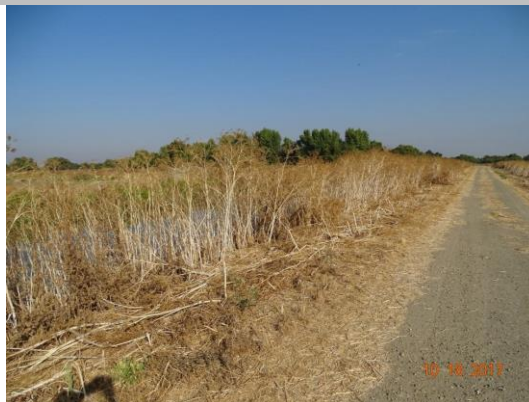
Photo 1 of 2 : SP\_2018\_NA0010\_120\_19\_20180307\_00006.jpg

LM Start	13.64	Rating **	U	Issue No.	19
LM End	13.75	Issue Type +	Ma	Location *	LS
Category	Earthen Levee			GPS Latitude/Longitude	
				Start	End
Item	Vegetation			37.173767 °	37.172157 °
				-120.761018 °	-120.761200 °
DWR ID	DWR_NA0010_02B_s _ 2017_19				
Comment Code					
V2 : Remove the wild growth other than native grasses from the levee slopes.					
Inspector Comment

Looking north at landside slope.

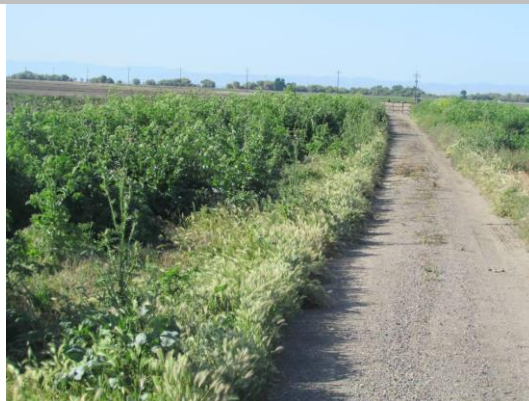
Photo 2 of 2 : SP\_2018\_NA0010\_120\_19\_20180307\_00007.jpg

LM Start	13.64	Rating **	U	Issue No.	19 (cont)	
LM End	13.75	Issue Type +	Ma	Location *	LS	
Category	Earthen Levee			GPS Latitude/Longitude		
				Start		End
Item	Vegetation			37.173767 °		37.172157 °
				-120.761018 °		-120.761200 °
DWR ID	DWR_NA0010_02B_s_2017_19					
Comment Code						
V2 : Remove the wild growth other than native grasses from the levee slopes.						
Inspector Comment

Looking northwest at dense veg on landward slope.

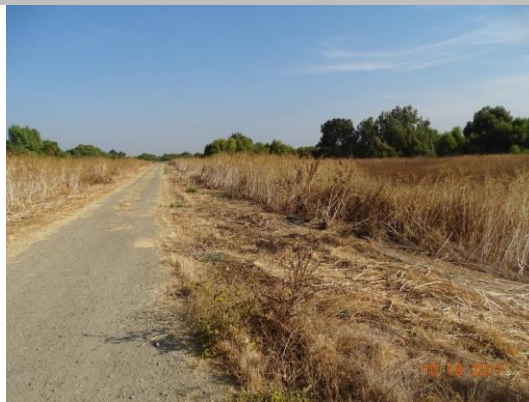
Photo 1 of 1 : SP\_2018\_NA0010\_120\_20\_20180307\_00008.jpg

LM Start	13.64	Rating **	U	Issue No.	20
LM End	13.75	Issue Type +	Ma	Location *	WS
Category	Earthen Levee			GPS Latitude/Longitude	
				Start	End
Item	Vegetation			37.173767 °	37.172157 °
				-120.761018 °	-120.761200 °
DWR ID	DWR_NA0010_02B_s_2017_20				
Comment Code					
V2 : Remove the wild growth other than native grasses from the levee slopes.					
Inspector Comment

Looking north at waterside slope.

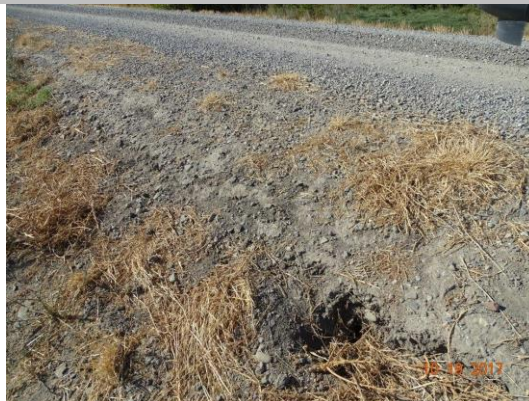
Photo 1 of 1 : SP\_2018\_NA0010\_121\_67\_20180307\_00004.jpg

LM Start	0.19	Rating **	M	Issue No.	67
LM End	0.19	Issue Type +	Ma	Location *	LS
Category	Earthen Levee			GPS Latitude/Longitude	
				Start	End
Item	Animal Control			37.109013 °	37.109013 °
				-120.587799 °	-120.587799 °
DWR ID	DWR_NA0010_03_s_2015_67				
Comment Code					
A3 : No rodents visible, but rodent burrows visible; need to backfill and compact or grout burrows.					
Inspector Comment					
Rodent holes noted at landside slope.

Looking southwest at the landside shoulder.

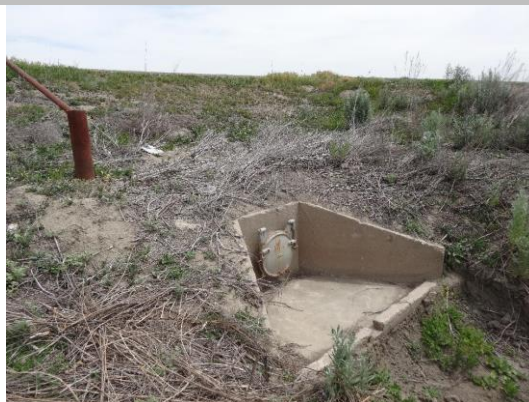
Photo 1 of 3 : UCIP\_SP\_2018\_34083\_61941.jpg

LM Start	0.42	Rating **	M	Issue No.	68	
LM End	0.42	Issue Type +	Ma	Location *		
Category	Supplemental			GPS Latitude/Longitude		
				Start	End	
Item	DWR UCIP LMA Responsibility			37.106233 °	37.106233 °	
				-120.585797 °	-120.585797 °	
DWR ID						
Comment Code						
Inspector Comment						
FS_ID:34083						
DS_ID:19691						
EP_NO: N/A						
Repair Type: Non-Urgent						
Crossing Status: Found						
UCIP Comments: Need to contact owner. Recommend removing tall grass on landward slope and clearing sediment build up inside pipe.						
FIELD_STRUCT_DESC: 24-inch corrugated metal gravity drainage pipe through the levee, 11.3 feet below the crown. Flap gate on the waterside (WS) end. [Additional Reference(s): DWR Levee Log, 2002. USACE San Joaquin O&M Manual 601.1, 1967, (HLM 0.43)].						
FS Date: 4/17/2014

Concrete structure and flap gate visible on waterward side.

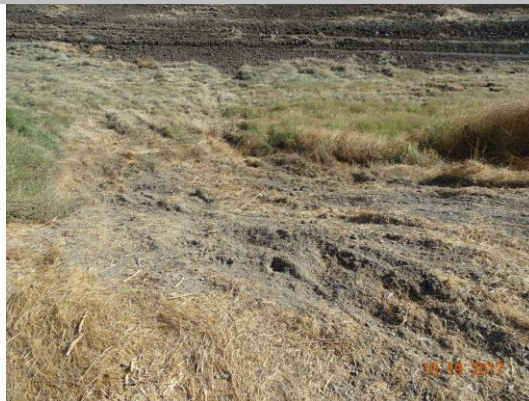
Photo 1 of 1 : SP\_2018\_NA0010\_121\_6\_20180307\_00002.jpg

LM Start	0.43	Rating **	M	Issue No.	6
LM End	0.43	Issue Type +	Ma	Location *	LS
Category	Earthen Levee			GPS Latitude/Longitude	
				Start	End
Item	Slope Stability			37.106121 °	37.106121 °
				-120.585680 °	-120.585680 °
DWR ID	DWR_NA0010_03_f_2017_6				
Comment Code					
S3 : Repair the levee slope damaged by vehicle traffic and prevent access where possible.					
Inspector Comment

Looking east at the landside slope.

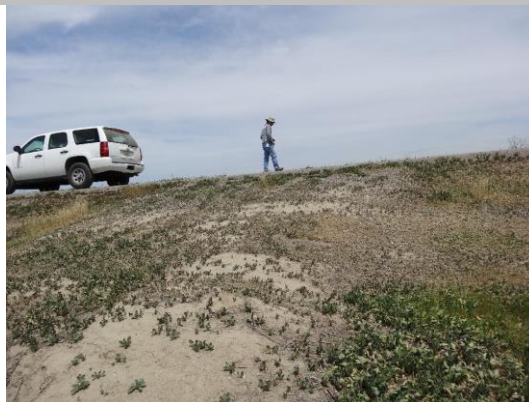
Photo 1 of 3 : UCIP\_SP\_2018\_36534\_66248.jpg

LM Start	0.76	Rating **	A/W	Issue No.	69	
LM End	0.76	Issue Type +	Ma	Location *		
Category	Supplemental			GPS Latitude/Longitude		
				Start	End	
Item	DWR UCIP LMA Responsibility			37.102964 °	37.102964 °	
				-120.581421 °	-120.581421 °	
DWR ID						
Comment Code						
Inspector Comment						
FS_ID:36534 DS_ID:19692 EP_NO: N/A Repair Type: No Action Needed Crossing Status: Found UCIP Comments: FIELD_STRUCT_DESC: 24-inch corrugated metal gravity drainage pipe through the levee, 9.3 feet below the crown. Flap gate on the waterside (WS) end. [Additional Reference(s): DWR Levee Log, 2002. USACE San Joaquin O&M Manual 601.1, 1967, (HLM 0.77)]. FS Date: 4/17/2014

View of waterward slope.

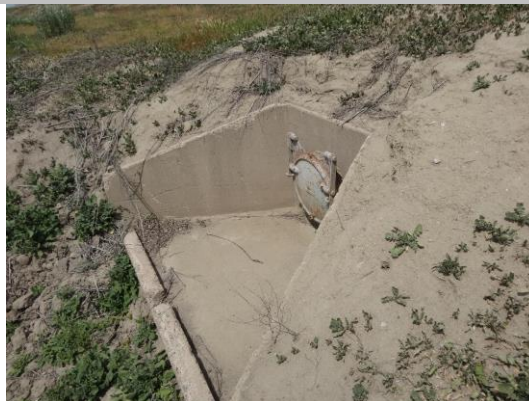
Photo 2 of 3 : UCIP\_SP\_2018\_36534\_66249.jpg

LM Start	0.76	Rating **	A/W	Issue No.	69 (cont)	
LM End	0.76	Issue Type +	Ma	Location *		
Category	Supplemental			GPS Latitude/Longitude		
				Start	End	
Item	DWR UCIP LMA Responsibility			37.102964 °	37.102964 °	
				-120.581421 °	-120.581421 °	
DWR ID						
Comment Code						
Inspector Comment						
FS_ID:36534						
DS_ID:19692						
EP_NO: N/A						
Repair Type: No Action Needed						
Crossing Status: Found						
UCIP Comments:						
FIELD_STRUCT_DESC: 24-inch corrugated metal gravity drainage pipe						
through the levee, 9.3 feet below the crown. Flap gate on the waterside						
(WS) end. [Additional Reference(s): DWR Levee Log, 2002. USACE						
San Joaquin O&M Manual 601.1, 1967, (HLM 0.77)].						
FS Date: 4/17/2014

Concrete structure located on waterward side.

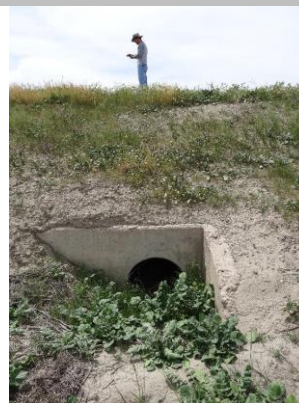
Photo 3 of 3 : UCIP\_SP\_2018\_36534\_66251.jpg

LM Start	<b>0.76</b>	Rating **	A/W	Issue No.	<b>69 (cont)</b>
LM End	<b>0.76</b>	Issue Type +	Ma	Location *

View of landward slope.

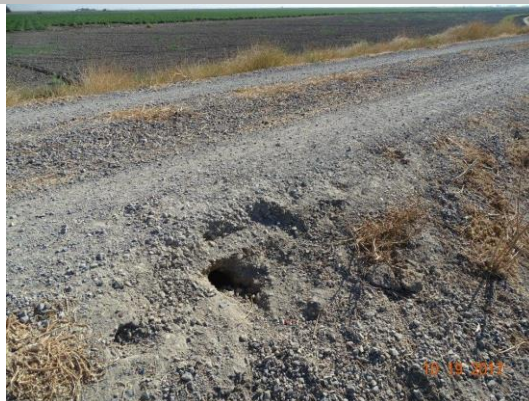
Photo 1 of 1 : SP\_2018\_NA0010\_121\_7\_20180307\_00003.jpg

LM Start	0.83	Rating **	M	Issue No.	7
LM End	0.83	Issue Type +	Ma	Location *	CR
Category	Earthen Levee			GPS Latitude/Longitude	
				Start	End
Item	Animal Control			37.102190 °	37.102190 °
				-120.580717 °	-120.580717 °
DWR ID	DWR_NA0010_03_f_2017_7				
Comment Code					
A1 : Exterminate rodents and backfill and compact or grout burrows.					
Inspector Comment

Looking southeast at the waterside shoulder.

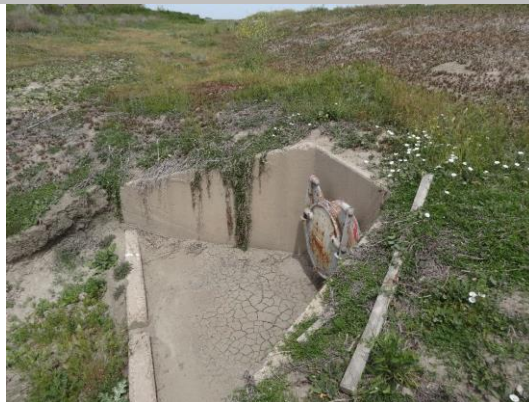
Photo 2 of 3 : UCIP\_SP\_2018\_39371\_66254.jpg

LM Start	1.71	Rating **	M	Issue No.	70 (cont)
LM End	1.71	Issue Type +	Ma	Location *

Concrete structure located on waterward side.

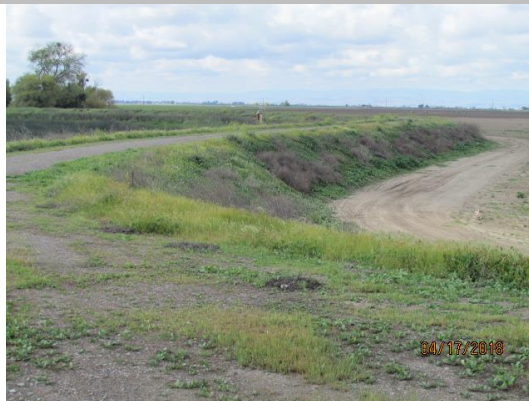
Photo 1 of 1 : SP\_2018\_NA0010\_122\_9\_20180420\_00023.jpg

LM Start	0.00	Rating **	M	Issue No.	9
LM End	1.40	Issue Type +	Ma	Location *	LS
Category	Earthen Levee			GPS Latitude/Longitude	
				Start	End
Item	Vegetation			37.112601 °	°
				-120.589042 °	°
DWR ID	DWR_NA0010_04_s_2018_9				
Comment Code					
V1 : Control annual grass and weeds on the levee slopes and easements.					
Inspector Comment

Looking north at typical view of landward slope. (Spring 2018)

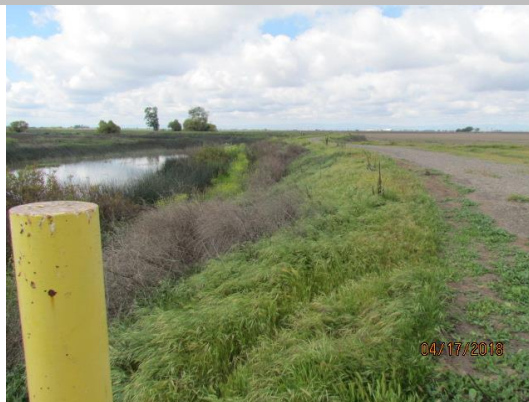
Photo 1 of 1 : SP\_2018\_NA0010\_122\_10\_20180420\_00024.jpg

LM Start	0.00	Rating **	M	Issue No.	10	
LM End	1.41	Issue Type +	Ma	Location *	WS	
Category	Earthen Levee			GPS Latitude/Longitude		
				Start		End
Item	Vegetation			37.112601 °		°
				-120.589042 °		°
DWR ID	DWR_NA0010_04_s_2018_10					
Comment Code						
V1 : Control annual grass and weeds on the levee slopes and easements.						
Inspector Comment

Looking north at typical view of waterward slope. (Spring 2018)

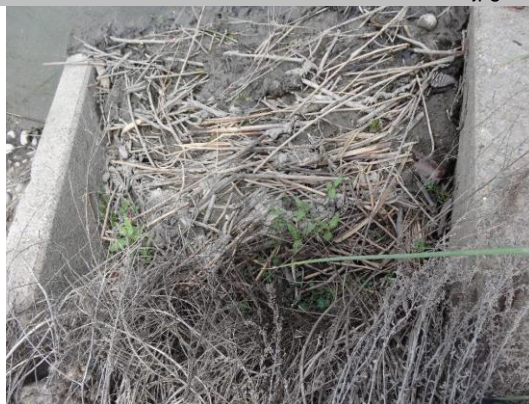
Photo 2 of 3 : UCIP\_SP\_2018\_34093\_61981.jpg

FS\_ID:34093  
DS\_ID:19695  
EP\_NO: N/A  
Repair Type: Non-Urgent  
Crossing Status: Found  
UCIP Comments: Sediment and debris blocking concrete headwall located on waterward side. During inspection water was flowing from landward side to waterward side. Recommend removing sediment to confirm condition of flap gate and pipe.  
FIELD\_STRUCT\_DESC: 36-inch corrugated metal gravity drainage pipe through the levee, 18 feet below the crown. Flap gate on the waterside (WS) end. Concrete headwall on each end. [Additional Reference(s): DWR Levee Log, 2002. USACE San Joaquin O&M Manual 601.1, 1967, (HLM 0.27)].  
FS Date: 4/17/2014

Sediment blocking flap gate located on waterward side.

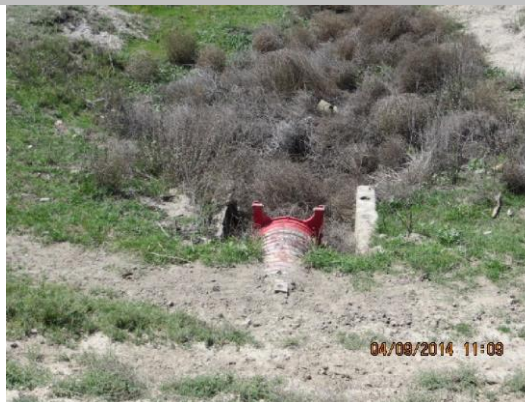
Photo 1 of 3 : UCIP\_SP\_2018\_39563\_60921.jpg

LM Start	0.08	Rating **	M	Issue No.	1311
LM End	0.08	Issue Type +	Ma	Location *	
Category	Supplemental			GPS Latitude/Longitude	
				Start	End
Item	DWR UCIP LMA Responsibility			37.278174 °	37.278174 °
				-120.823465 °	-120.823465 °
DWR ID					
Comment Code					
Inspector Comment					
FS_ID:39563 DS_ID:19756 EP_NO: N/A Repair Type: Non-Urgent Crossing Status: Found UCIP Comments: Debris blocking landward headwall--recommend clearing. FIELD_STRUCT_DESC: 24-inch corrugated metal gravity drainage pipe through the levee, 8.6 feet below the crown. Concrete U-shaped headwall and flap gate on the waterside (WS) end. Concrete headwall on the landside (LS) end. [Additional Reference(s): DWR Levee Log, 2002. USACE San Joaquin O&M Manual 601.1, 1967, (HLM 0.07)]. FS Date: 4/9/2014

Pipe, flapgate, and concrete headwall on WS toe.

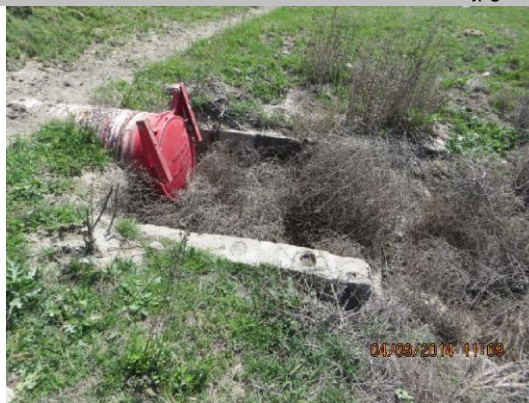
Photo 2 of 3 : UCIP\_SP\_2018\_39563\_60920.jpg

LM Start	0.08	Rating **	M	Issue No.	1311 (cont)	
LM End	0.08	Issue Type +	Ma	Location *		
Category	Supplemental			GPS Latitude/Longitude		
				Start	End	
Item	DWR UCIP LMA Responsibility			37.278174 °	37.278174 °	
				-120.823465 °	-120.823465 °	
DWR ID						
Comment Code						
Inspector Comment						
FS_ID:39563 DS_ID:19756 EP_NO: N/A Repair Type: Non-Urgent Crossing Status: Found UCIP Comments: Debris blocking landward headwall--recommend clearing. FIELD_STRUCT_DESC: 24-inch corrugated metal gravity drainage pipe through the levee, 8.6 feet below the crown. Concrete U-shaped headwall and flap gate on the waterside (WS) end. Concrete headwall on the landside (LS) end. [Additional Reference(s): DWR Levee Log, 2002. USACE San Joaquin O&M Manual 601.1, 1967, (HLM 0.07)]. FS Date: 4/9/2014

Pipe, flapgate, and concrete headwall on WS toe.

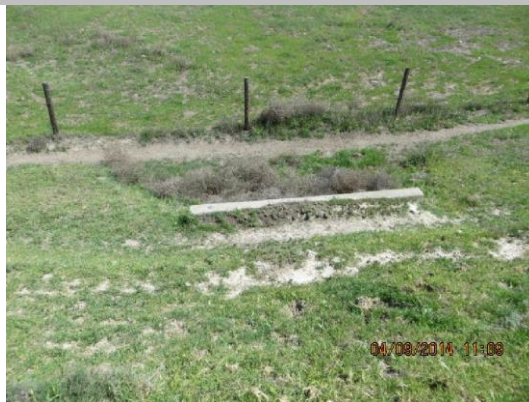
Photo 3 of 3 : UCIP\_SP\_2018\_39563\_60922.jpg

Pipe and concrete headwall on LS toe.

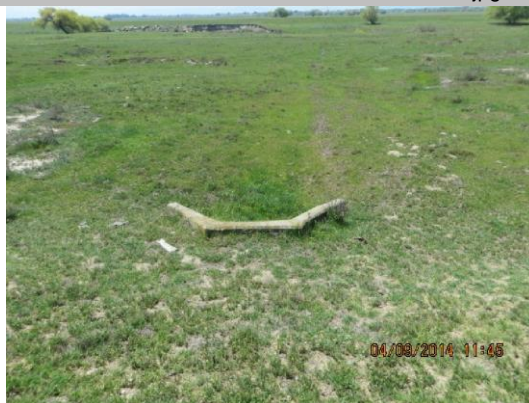
Photo 1 of 3 : UCIP\_SP\_2018\_39584\_60926.jpg

LM Start	0.60	Rating **	M	Issue No.	1313	
LM End	0.60	Issue Type +	Ma	Location *		
Category	Supplemental			GPS Latitude/Longitude		
				Start		End
Item	DWR UCIP LMA Responsibility			37.273945 °		37.273945 °
				-120.815835 °		-120.815835 °
DWR ID						
Comment Code						
Inspector Comment						
FS_ID:39584						
DS_ID:19757						
EP_NO: N/A						
Repair Type: Non-Urgent						
Crossing Status: Found						
UCIP Comments: Excess debris on landward headwall--recommend clearing.						
FIELD_STRUCT_DESC: 30-inch corrugated metal gravity drainage pipe through the levee, 7.5 feet below the crown. Flap gate on the waterside (WS) end. Concrete headwall on the landside (LS) end. Concrete U-shaped headwall on the WS end. [Additional Reference(s): DWR Levee Log, 2002. USACE San Joaquin O&M Manual 601.1, 1967, (HLM 0.59)].						
FS Date: 4/9/2014

Concrete headwall, pipe, and flapgate on WS toe.

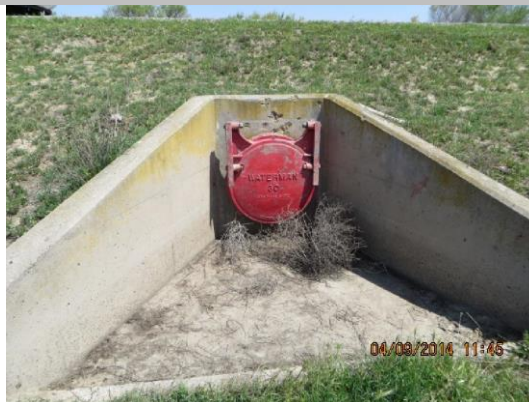
Photo 2 of 3 : UCIP\_SP\_2018\_39584\_60925.jpg

Concrete headwall, pipe, and flapgate on WS toe.

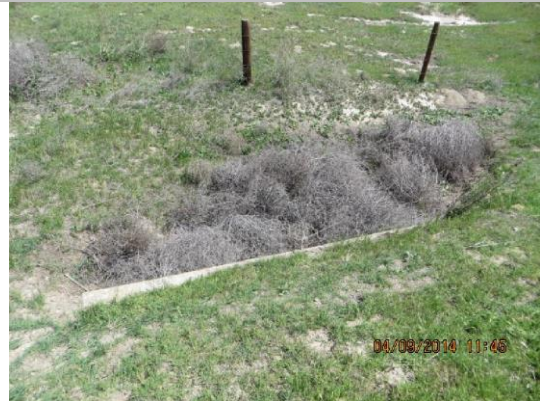
Photo 3 of 3 : UCIP\_SP\_2018\_39584\_60927.jpg

LM Start	0.60	Rating **	M	Issue No.	1313 (cont)	
LM End	0.60	Issue Type +	Ma	Location *		
Category	Supplemental			GPS Latitude/Longitude		
				Start	End	
Item	DWR UCIP LMA Responsibility			37.273945 °	37.273945 °	
				-120.815835 °	-120.815835 °	
DWR ID						
Comment Code						
Inspector Comment						
FS_ID:39584 DS_ID:19757 EP_NO: N/A Repair Type: Non-Urgent Crossing Status: Found UCIP Comments: Excess debris on landward headwall--recommend clearing. FIELD_STRUCT_DESC: 30-inch corrugated metal gravity drainage pipe through the levee, 7.5 feet below the crown. Flap gate on the waterside (WS) end. Concrete headwall on the landside (LS) end. Concrete U-shaped headwall on the WS end. [Additional Reference(s): DWR Levee Log, 2002. USACE San Joaquin O&M Manual 601.1, 1967, (HLM 0.59)]. FS Date: 4/9/2014

Pipe and concrete headwall on LS toe. Note vegetation buildup.

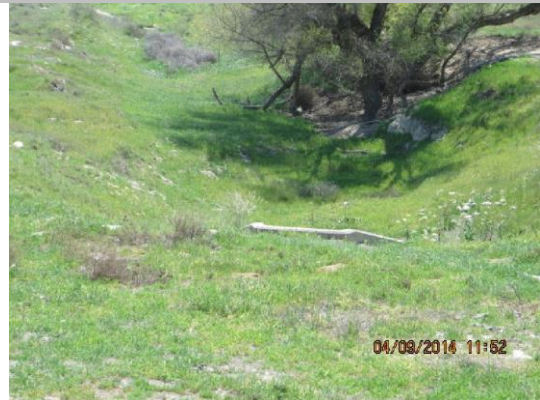
Photo 1 of 3 : UCIP\_SP\_2018\_39585\_60931.jpg

Comment Code					
Inspector Comment					
FS_ID:39585 DS_ID:19758 EP_NO: N/A Repair Type: Non-Urgent Crossing Status: Found UCIP Comments: Dense vegetation limits the inspector's visibility to identify signs of pipe failure (leaks) along the landward slope. Recommend removing vegetation along pipe alignment to conduct proper inspection of structure. FIELD_STRUCT_DESC: 36-inch corrugated metal gravity drainage pipe through the levee, 13.2 feet below the crown. Flap gate on the waterside (WS) end. Concrete headwall on the landside (LS) end. Concrete U-shaped headwall on the WS end. Cobble revetment around both ends. [Additional Reference(s): DWR Levee Log, 2002. USACE San Joaquin O&M Manual 601.1, 1967, (HLM 0.65)]. FS Date: 4/9/2014

Concrete headwall visible off WS toe.

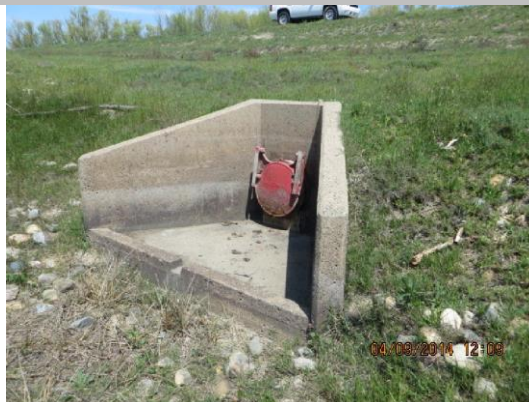
Photo 2 of 3 : UCIP\_SP\_2018\_33707\_60933.jpg

Pipe, flapgate, and headwall at WS toe.

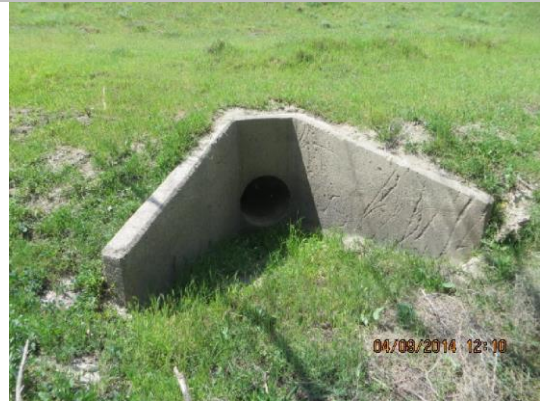
Photo 3 of 3 : UCIP\_SP\_2018\_33707\_60936.jpg

LM Start	0.85	Rating **	A/W	Issue No.	1315 (cont)
LM End	0.85	Issue Type +	Ma	Location *	
Category	Supplemental			GPS Latitude/Longitude	
				Start	End
Item	DWR UCIP LMA Responsibility			37.271894 °	37.271894 °
				-120.812224 °	-120.812224 °
DWR ID					
Comment Code					
Inspector Comment					
FS_ID:33707 DS_ID:19759 EP_NO: N/A Repair Type: No Action Needed Crossing Status: Found UCIP Comments: FIELD_STRUCT_DESC: 24-inch corrugated metal gravity drainage pipe through the levee, 14.4 feet below the crown. Flap gate on the waterside (WS) end. Concrete headwall on the landside (LS) end. Concrete U-shaped headwall on the WS end. [Additional Reference(s): DWR Levee Log, 2002. USACE San Joaquin O&M Manual 601.1, 1967, (HLM 0.84)]. FS Date: 4/9/2014

Pipe and concrete headwall at LS toe.

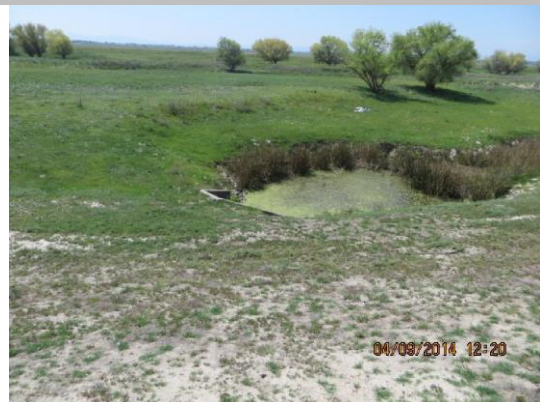
Photo 1 of 3 : UCIP\_SP\_2018\_33708\_60939.jpg

LM Start	1.45	Rating **	A/W	Issue No.	1316
LM End	1.45	Issue Type +	Ma	Location *	
Category	Supplemental			GPS Latitude/Longitude	
				Start	End
Item	DWR UCIP LMA Responsibility			37.265804 °	37.265804 °
				-120.804955 °	-120.804955 °
DWR ID					
Comment Code					
Inspector Comment					
FS_ID:33708					
DS_ID:19760					
EP_NO: N/A					
Repair Type: No Action Needed					
Crossing Status: Found					
UCIP Comments:					
FIELD_STRUCT_DESC: 36-inch corrugated metal gravity drainage pipe through the levee, 21 feet below the crown. Flap gate on the waterside (WS) end. Concrete headwall on the landside (LS) end. Concrete U-shaped headwall on the WS end. [Additional Reference(s): DWR Levee Log, 2002. USACE San Joaquin O&M Manual 601.1, 1967, (HLM 1.44)].					
FS Date: 4/9/2014

Flapgate on concrete headwall at WS toe.

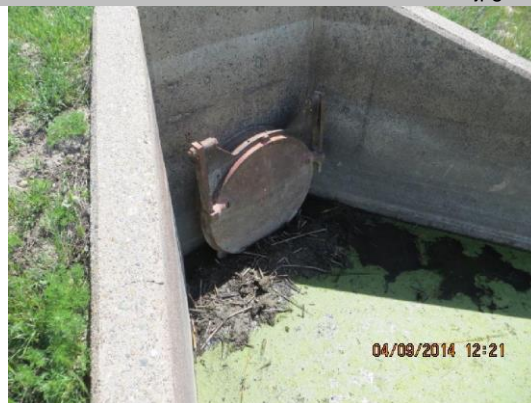
Photo 2 of 3 : UCIP\_SP\_2018\_33708\_60938.jpg

Flapgate on concrete headwall at WS toe.

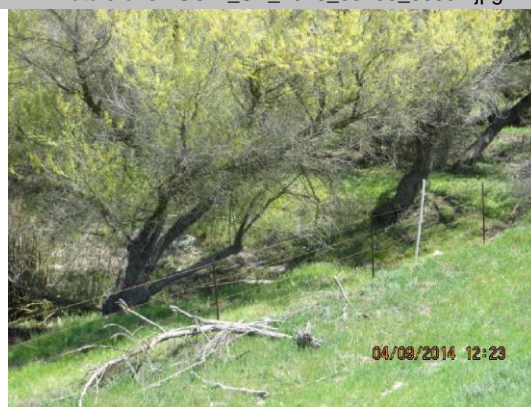
Photo 3 of 3 : UCIP\_SP\_2018\_33708\_60937.jpg

Pipe and concrete headwall on LS toe.

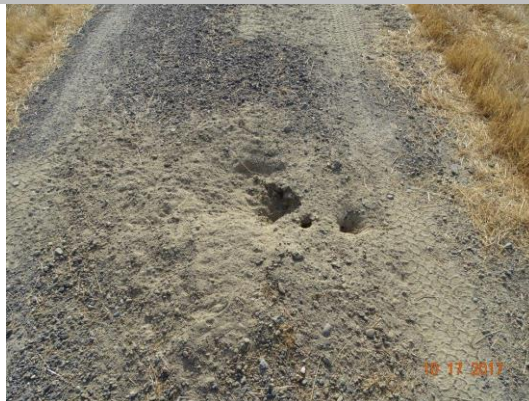
Photo 1 of 1 : SP\_2018\_NA0010\_123\_113\_20180307\_00022.jpg

LM Start	2.39	Rating **	A/W	Issue No.	113
LM End	2.40	Issue Type +	Ma	Location *	CR
Category	Earthen Levee			GPS Latitude/Longitude	
				Start	End
Item	Animal Control			37.257060 °	37.256981 °
				-120.792823 °	-120.792707 °
DWR ID	DWR_NA0010_05_f_2017_113				
Comment Code					
A3 : No rodents visible, but rodent burrows visible; need to backfill and compact or grout burrows.					
Inspector Comment					
LMA graded levee crown and backfilled rodent holes. Need to monitor site.

Looking at rodent holes on the levee crown.

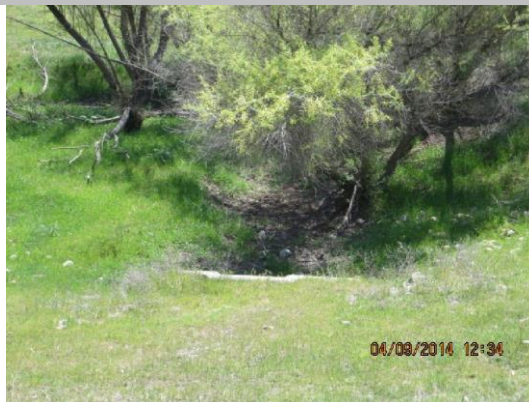
Photo 1 of 3 : UCIP\_SP\_2018\_33709\_60943.jpg

LM Start	2.84	Rating **	M	Issue No.	1317
LM End	2.84	Issue Type +	Ma	Location *	
Category	Supplemental			GPS Latitude/Longitude	
				Start	End
Item	DWR UCIP LMA Responsibility			37.256810 °	37.256810 °
				-120.785113 °	-120.785113 °
DWR ID					
Comment Code					
Inspector Comment					
FS_ID:33709					
DS_ID:19809					
EP_NO: N/A					
Repair Type: Non-Urgent					
Crossing Status: Found					
UCIP Comments: Log partially blocking inlet at LS toe.					
FIELD_STRUCT_DESC: 24-inch corrugated metal gravity drainage pipe					
through the levee, 15 feet below the crown. Flap gate on the waterside					
(WS) end. Concrete U-shaped headwall on each end. [Additional					
Reference(s): DWR Levee Log, 2002. USACE San Joaquin O&M					
Manual 601.1, 1967, (HLM 2.85)].					
FS Date: 4/9/2014

Concrete headwall at outlet on WS toe.

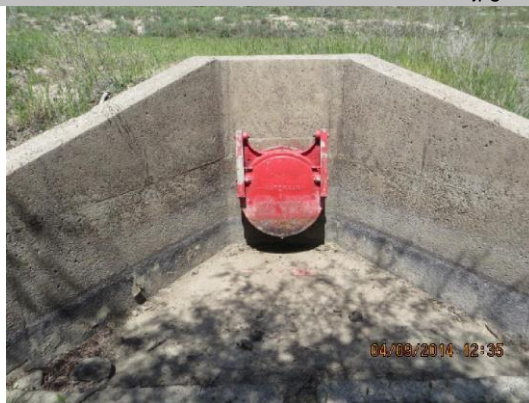
Photo 2 of 3 : UCIP\_SP\_2018\_33709\_60941.jpg

Headwall, pipe, and flapgate on WS toe.

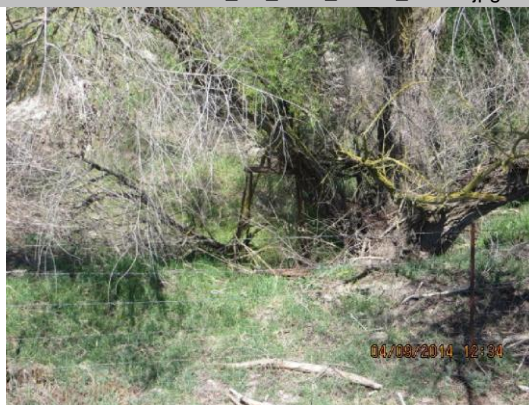
Photo 3 of 3 : UCIP\_SP\_2018\_33709\_60942.jpg

Concrete headwall and metal gate hoist on LS toe.

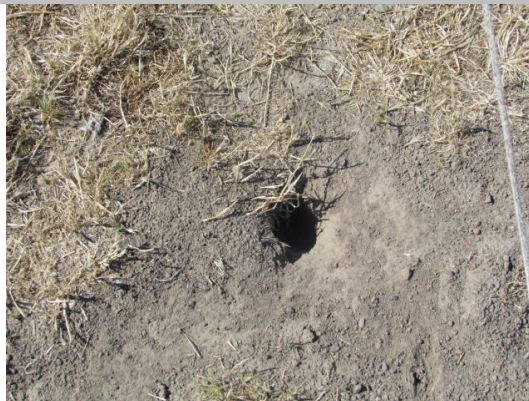
Photo 1 of 1 : SP\_2018\_NA0010\_123\_6\_20180307\_00006.jpg

LM Start	3.20	Rating **	A/W	Issue No.	6
LM End	3.35	Issue Type +	Ma	Location *	WS
Category	Earthen Levee			GPS Latitude/Longitude	
				Start	End
Item	Animal Control			37.256635 °	37.255170 °
				-120.778935 °	-120.776882 °
DWR ID	DWR_NA0010_05_s_2014_6				
Comment Code					
A1 : Exterminate rodents and backfill and compact or grout burrows.					
Inspector Comment					
No rodent visible but several rodent holes visible on levee crown. LMA graded levee crown and backfilled rodent holes.

Looking at typical view of rodent holes on waterward slope.

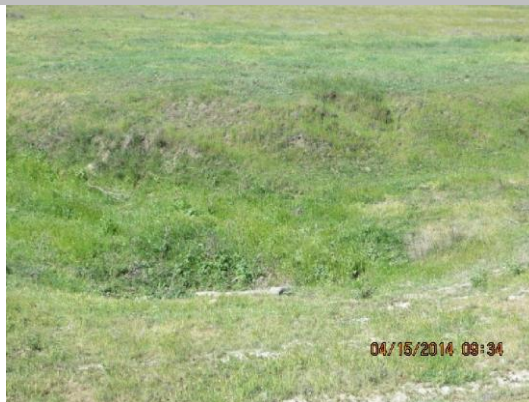
Photo 1 of 3 : UCIP\_SP\_2018\_43055\_60948.jpg

LM Start	3.34	Rating **	M	Issue No.	1318
LM End	3.34	Issue Type +	Ma	Location *	
Category	Supplemental			GPS Latitude/Longitude	
				Start	End
Item	DWR UCIP LMA Responsibility			37.255258 °	37.255258 °
				-120.776996 °	-120.776996 °
DWR ID					
Comment Code					
Inspector Comment					
FS_ID:43055					
DS_ID:19810					
EP_NO: N/A					
Repair Type: Non-Urgent					
Crossing Status: Found					
UCIP Comments: Pipe corroded through at flapgate on WS toe.					
FIELD_STRUCT_DESC: 24-inch corrugated metal gravity drainage pipe through the levee, 14.7 feet below the crown. Flap gate on the waterside (WS) end. Concrete U-shaped headwall on each end.					
[Additional Reference(s): DWR Levee Log, 2002. USACE San Joaquin O&M Manual 601.1, 1967, (HLM 3.33)].					
FS Date: 4/15/2014

Concrete headwall at WS toe.

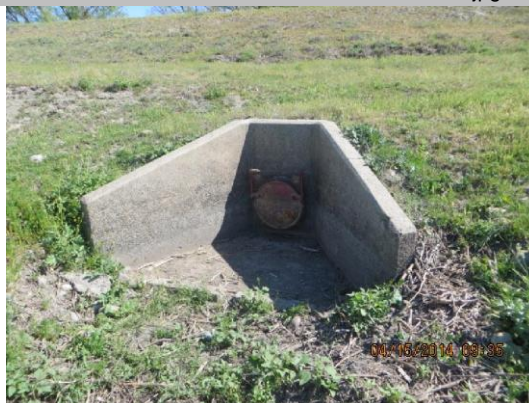
Photo 2 of 3 : UCIP\_SP\_2018\_43055\_60946.jpg

LM Start	3.34	Rating **	M	Issue No.	1318 (cont)	
LM End	3.34	Issue Type +	Ma	Location *		
Category	Supplemental			GPS Latitude/Longitude		
				Start	End	
Item	DWR UCIP LMA Responsibility			37.255258 °	37.255258 °	
				-120.776996 °	-120.776996 °	
DWR ID						
Comment Code						
Inspector Comment						
FS_ID:43055						
DS_ID:19810						
EP_NO: N/A						
Repair Type: Non-Urgent						
Crossing Status: Found						
UCIP Comments: Pipe corroded through at flapgate on WS toe.						
FIELD_STRUCT_DESC: 24-inch corrugated metal gravity drainage pipe						
through the levee, 14.7 feet below the crown. Flap gate on the						
waterside (WS) end. Concrete U-shaped headwall on each end.						
[Additional Reference(s): DWR Levee Log, 2002. USACE San Joaquin						
O&M Manual 601.1, 1967, (HLM 3.33)].						
FS Date: 4/15/2014

Flapgate and Concrete headwall at WS toe.

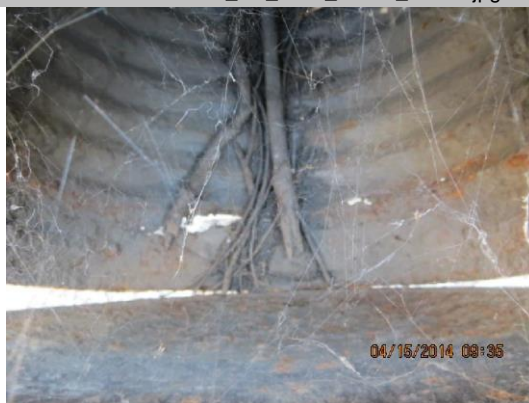
Photo 3 of 3 : UCIP\_SP\_2018\_43055\_60951.jpg

Pipe corroded through just behind flapgate at WS toe.

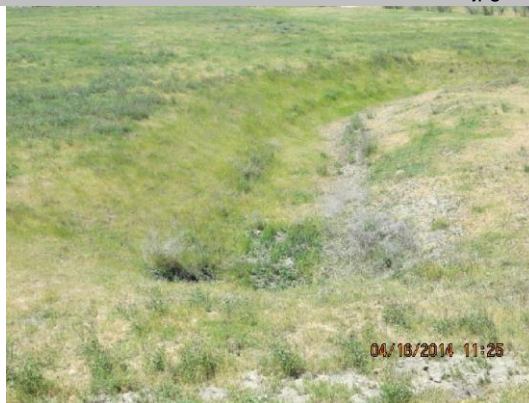
Photo 3 of 3 : UCIP\_SP\_2018\_39586\_61136.jpg

LM Start	3.68	Rating **	M	Issue No.	1319 (cont)
LM End	3.68	Issue Type +	Ma	Location *	
Category	Supplemental			GPS Latitude/Longitude	
				Start	End
Item	DWR UCIP LMA Responsibility			37.252308 °	37.252308 °
				-120.768038 °	-120.768038 °
DWR ID					
Comment Code					
Inspector Comment					
FS_ID:39586 DS_ID:19811 EP_NO: N/A Repair Type: Non-Urgent Crossing Status: Found UCIP Comments: Sediment buildup in pipe visible from landward side--recommend contacting owner to clear pipe. FIELD_STRUCT_DESC: 24-inch corrugated metal gravity drainage pipe through the levee, 15 feet below the crown. Flap gate on the waterside (WS) end. Concrete headwall on the landside (LS) end. Concrete U-shaped headwall on the WS end. [Additional Reference(s): DWR Levee Log, 2002. USACE San Joaquin O&M Manual 601.1, 1967, (HLM 3.67)]. FS Date: 4/16/2014

Pipe and headwall on LS toe.

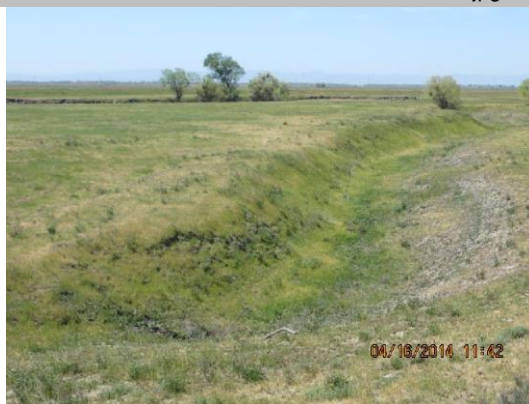
Photo 1 of 3 : UCIP\_SP\_2018\_39880\_61142.jpg

LM Start	4.02	Rating **	M	Issue No.	1320
LM End	4.02	Issue Type +	Ma	Location *	
Category	Supplemental			GPS Latitude/Longitude	
				Start	End
Item	DWR UCIP LMA Responsibility			37.248432 °	37.248432 °
				-120.764066 °	-120.764066 °
DWR ID					
Comment Code					
Inspector Comment					
FS_ID:39880 DS_ID:19769 EP_NO: N/A Repair Type: Non-Urgent Crossing Status: Found UCIP Comments: Sediment buildup in pipe visible from landward side--recommend contacting owner to clear pipe. FIELD_STRUCT_DESC: 24-inch corrugated metal gravity drainage pipe through the levee, 16 feet below the crown. Flap gate on the waterside (WS) end. Concrete U-shaped headwall on each end. [Additional Reference(s): DWR Levee Log, 2002. USACE San Joaquin O&M Manual 601.1, 1967, (HLM 4.02)]. FS Date: 4/16/2014

Pipe, headwall, and flapgate on WS toe.

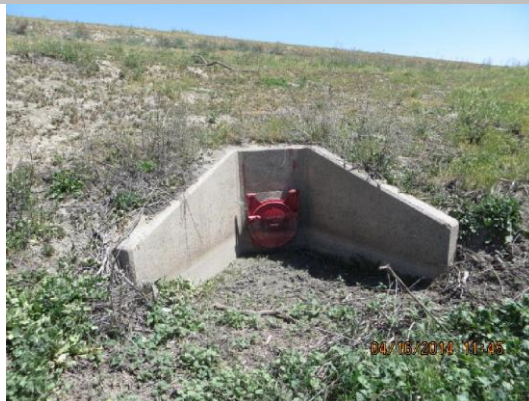
Photo 2 of 3 : UCIP\_SP\_2018\_39880\_61143.jpg

Pipe, headwall, and flapgate on WS toe.

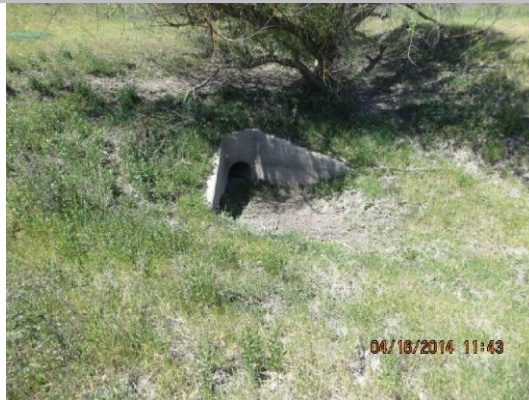
Photo 3 of 3 : UCIP\_SP\_2018\_39880\_61141.jpg

Pipe and headwall on LS toe.

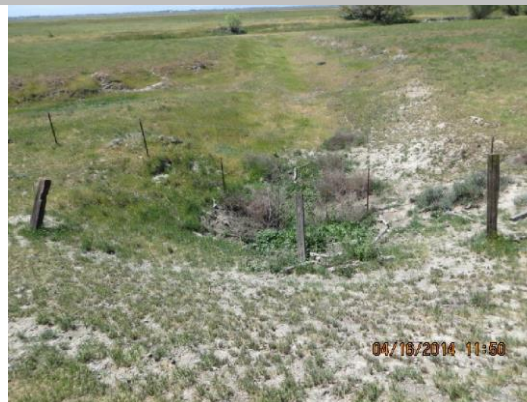
Photo 1 of 3 : UCIP\_SP\_2018\_39588\_61146.jpg

LM Start	4.27	Rating **	M	Issue No.	1321
LM End	4.27	Issue Type +	Ma	Location *	
Category	Supplemental			GPS Latitude/Longitude	
				Start	End
Item	DWR UCIP LMA Responsibility			37.246008 °	37.246008 °
				-120.760706 °	-120.760706 °
DWR ID					
Comment Code					
Inspector Comment					
FS_ID:39588 DS_ID:19770 EP_NO: N/A Repair Type: Non-Urgent Crossing Status: Found UCIP Comments: Sediment buildup in pipe visible from landward side-- recommend contacting owner to clear pipe. FIELD_STRUCT_DESC: 24-inch corrugated metal gravity drainage pipe through the levee, 11.6 feet below the crown. Flap gate on the waterside (WS) end. Concrete headwall on the landside (LS) end. Concrete U-shaped headwall on the WS end. [Additional Reference(s): DWR Levee Log, 2002. USACE San Joaquin O&M Manual 601.1, 1967, (HLM 4.27)]. FS Date: 4/16/2014

Pipe, headwall, and flapgate on WS toe.

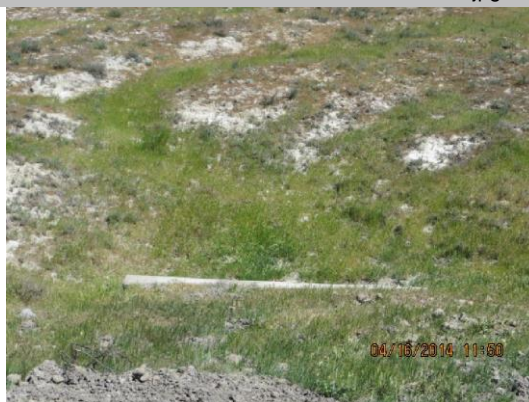
Photo 3 of 3 : UCIP\_SP\_2018\_39588\_61147.jpg

Concrete headwall and pipe on LS toe.
