**Flood Control Project Maintenance  
Levee Inspections**

## Maintenance Issue Types Only, Levee Inspection Report By Mile - Spring 2018

### Lower San Joaquin Levee District

Waterway	Bank	Unit Miles	Inspection Start/End	Inspector
Unit No. 01 San Joaquin River	Right	22.52	04/04/2018 04/16/2018	Richard Willoughby

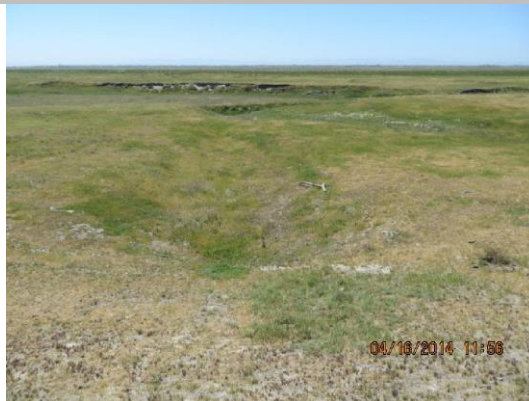
Photo 1 of 3 : UCIP\_SP\_2018\_39589\_62081.jpg

LM Start	4.55	Rating **	M	Issue No.	1322
LM End	4.55	Issue Type +	Ma	Location *	
Category	Supplemental			GPS Latitude/Longitude	
				Start	End
Item	DWR UCIP LMA Responsibility			37.243668 °	37.243668 °
				-120.756812 °	-120.756812 °
DWR ID					
Comment Code					
Inspector Comment					
FS_ID:39589 DS_ID:19771 EP_NO: N/A Repair Type: Non-Urgent Crossing Status: Found UCIP Comments: Sediment buildup in pipe visible from landward side--recommend contacting owner to clear pipe. FIELD_STRUCT_DESC: 24-inch corrugated metal gravity drainage pipe through the levee, 12 feet below the crown. Flap gate on the waterside (WS) end. Concrete headwall on the landside (LS) end. Concrete U-shaped headwall on the WS end. [Additional Reference(s): DWR Levee Log, 2002. USACE San Joaquin O&M Manual 601.1, 1967, (HLM 4.54)]. FS Date: 4/16/2014 8:16:00 AM

Pipe, flapgate, and headwall on WS toe.

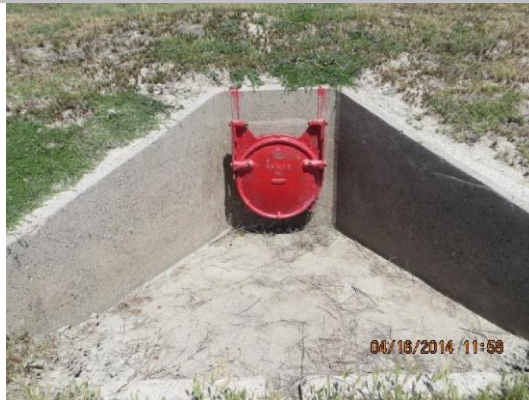
Photo 2 of 3 : UCIP\_SP\_2018\_39589\_62083.jpg

Pipe, flapgate, and headwall on WS toe.

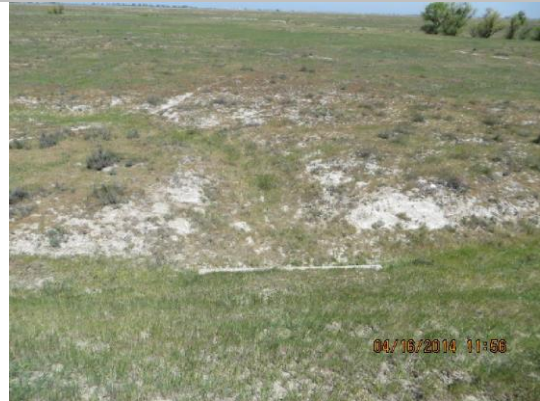
Photo 3 of 3 : UCIP\_SP\_2018\_39589\_62082.jpg

Pipe and headwall on LS toe.

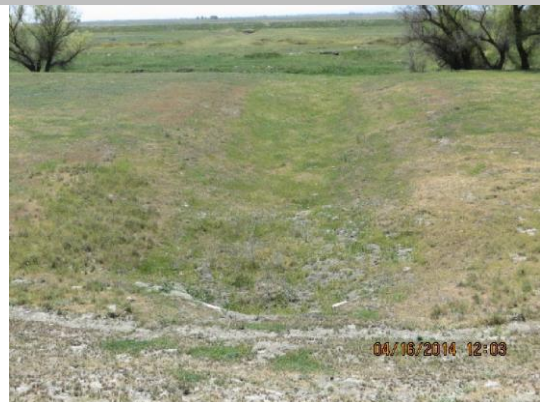
Photo 1 of 3 : UCIP\_SP\_2018\_39590\_62087.jpg

LM Start	4.89	Rating **	M	Issue No.	1323
LM End	4.89	Issue Type +	Ma	Location *	
Category	Supplemental			GPS Latitude/Longitude	
				Start	End
Item	DWR UCIP LMA Responsibility			37.240978 °	37.240978 °
				-120.751613 °	-120.751613 °
DWR ID					
Comment Code					
Inspector Comment					
FS_ID:39590 DS_ID:19772 EP_NO: N/A Repair Type: Non-Urgent Crossing Status: Found UCIP Comments: Heavy sediment buildup in pipe visible from landward side--recommend contacting owner to clear pipe. FIELD_STRUCT_DESC: 24-inch corrugated metal gravity drainage pipe through the levee, 12.3 feet below the crown. Flap gate on the waterside (WS) end. Concrete headwall on the landside (LS) end. Concrete U-shaped headwall on the WS end. [Additional Reference(s): DWR Levee Log, 2002. USACE San Joaquin O&M Manual 601.1, 1967, (HLM 4.89)]. FS Date: 4/16/2014

Headwall, flapgate, and pipe on WS toe.

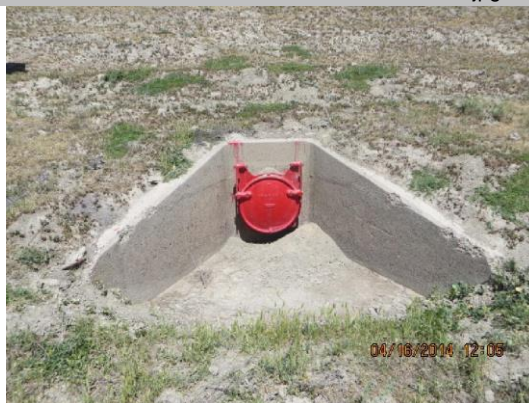
Photo 2 of 3 : UCIP\_SP\_2018\_39590\_62088.jpg

Headwall, flapgate, and pipe on WS toe.

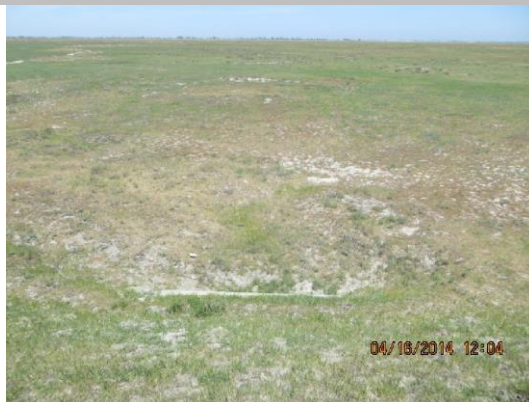
Photo 3 of 3 : UCIP\_SP\_2018\_39590\_62086.jpg

Headwall and pipe on LS toe.

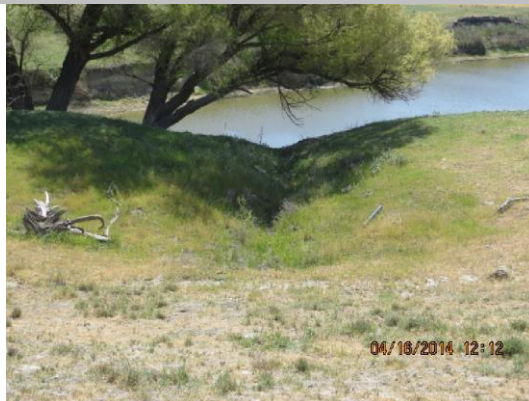
Photo 1 of 3 : UCIP\_SP\_2018\_39591\_62091.jpg

LM Start	5.15	Rating **	M	Issue No.	1324
LM End	5.15	Issue Type +	Ma	Location *	
Category	Supplemental			GPS Latitude/Longitude	
				Start	End
Item	DWR UCIP LMA Responsibility			37.240607 °	37.240607 °
				-120.746916 °	-120.746916 °
DWR ID					
Comment Code					
Inspector Comment					
FS_ID:39591 DS_ID:19773 EP_NO: N/A Repair Type: Non-Urgent Crossing Status: Found UCIP Comments: Heavy sediment buildup in pipe visible from landward side--recommend contacting owner to clear pipe. FIELD_STRUCT_DESC: 24-inch corrugated metal gravity drainage pipe through the levee, 12.2 feet below the crown. Flap gate on the waterside (WS) end. Concrete headwall on the landside (LS) end. Concrete U-shaped headwall on the WS end. [Additional Reference(s): DWR Levee Log, 2002. USACE San Joaquin O&M Manual 601.1, 1967, (HLM 5.15)]. FS Date: 4/16/2014

Headwall, flapgate, and pipe on WS toe.

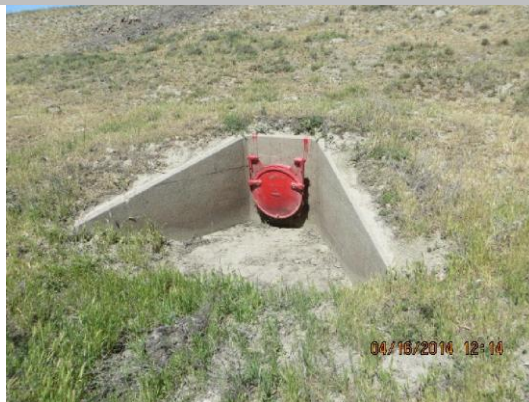
Photo 2 of 3 : UCIP\_SP\_2018\_39591\_62093.jpg

Headwall, flapgate, and pipe on WS toe.

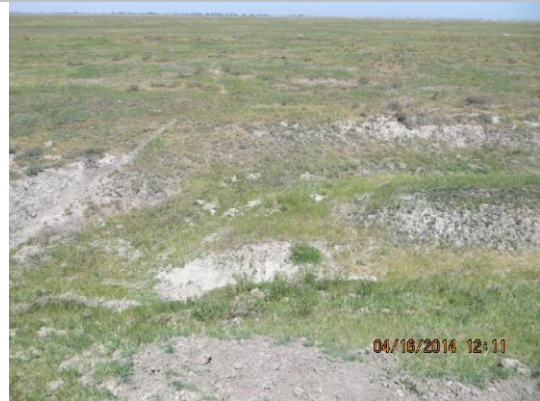
Photo 3 of 3 : UCIP\_SP\_2018\_39591\_62092.jpg

LM Start	5.15	Rating **	M	Issue No.	1324 (cont)
LM End	5.15	Issue Type +	Ma	Location *	
Category	Supplemental			GPS Latitude/Longitude	
				Start	End
Item	DWR UCIP LMA Responsibility			37.240607 °	37.240607 °
				-120.746916 °	-120.746916 °
DWR ID					
Comment Code					
Inspector Comment					
FS_ID:39591 DS_ID:19773 EP_NO: N/A Repair Type: Non-Urgent Crossing Status: Found UCIP Comments: Heavy sediment buildup in pipe visible from landward side--recommend contacting owner to clear pipe. FIELD_STRUCT_DESC: 24-inch corrugated metal gravity drainage pipe through the levee, 12.2 feet below the crown. Flap gate on the waterside (WS) end. Concrete headwall on the landside (LS) end. Concrete U-shaped headwall on the WS end. [Additional Reference(s): DWR Levee Log, 2002. USACE San Joaquin O&M Manual 601.1, 1967, (HLM 5.15)]. FS Date: 4/16/2014

Headwall and pipe on LS toe.

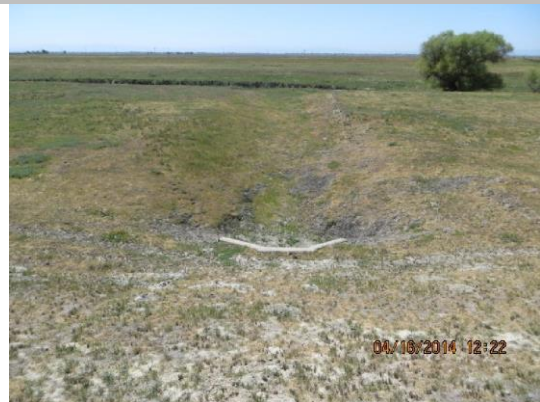
Photo 1 of 3 : UCIP\_SP\_2018\_34151\_62096.jpg

LM Start	5.58	Rating **	A/W	Issue No.	1325	
LM End	5.58	Issue Type +	Ma	Location *		
Category	Supplemental			GPS Latitude/Longitude		
				Start	End	
Item	DWR UCIP LMA Responsibility			37.238879 °	37.238879 °	
				-120.739719 °	-120.739719 °	
DWR ID						
Comment Code						
Inspector Comment						
FS_ID:34151						
DS_ID:19774						
EP_NO: N/A						
Repair Type: No Action Needed						
Crossing Status: Found						
UCIP Comments:						
FIELD_STRUCT_DESC: 24-inch corrugated metal gravity drainage pipe						
through the levee, 9.5 feet below the crown. Flap gate on the waterside						
(WS) end. Concrete headwall on the landside (LS) end. Concrete U-						
shaped headwall on the WS end. [Additional Reference(s): DWR Levee						
Log, 2002. USACE San Joaquin O&M Manual 601.1, 1967, (HLM 5.58)].						
FS Date: 4/16/2014

Headwall, flapgate, and pipe on WS toe.

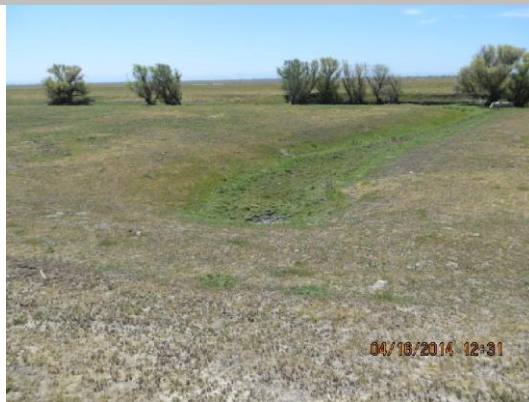
Photo 1 of 3 : UCIP\_SP\_2018\_34163\_62102.jpg

LM Start	6.35	Rating **	A/W	Issue No.	1326
LM End	6.35	Issue Type +	Ma	Location *	
Category	Supplemental			GPS Latitude/Longitude	
				Start	End
Item	DWR UCIP LMA Responsibility			37.232589 °	37.232589 °
				-120.728822 °	-120.728822 °
DWR ID					
Comment Code					
Inspector Comment					
FS_ID:34163 DS_ID:19775 EP_NO: N/A Repair Type: No Action Needed Crossing Status: Found UCIP Comments: FIELD_STRUCT_DESC: 24-inch corrugated metal gravity drainage pipe through the levee, 13 feet below the crown. Flap gate on the waterside (WS) end. Concrete headwall on the landside (LS) end. Concrete U-shaped headwall on the WS end. [Additional Reference(s): DWR Levee Log, 2002. USACE San Joaquin O&M Manual 601.1, 1967, (HLM 6.35)]. FS Date: 4/16/2014

Headwall, flapgate, and pipe on WS toe.

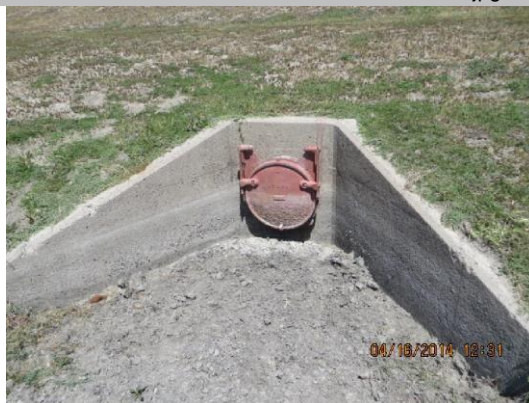
Photo 2 of 3 : UCIP\_SP\_2018\_34163\_62101.jpg

Headwall, flapgate, and pipe on WS toe.

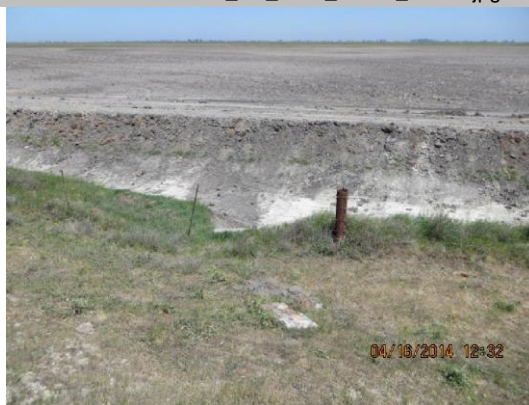
Photo 3 of 3 : UCIP\_SP\_2018\_34163\_62100.jpg

Headwall and pipe on LS toe.

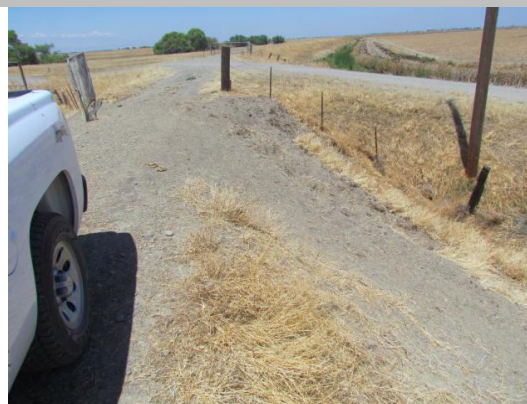
Photo 1 of 2 : SP\_2018\_NA0010\_123\_1309\_20180307\_00037.jpg

LM Start	6.59	Rating **	M	Issue No.	1309
LM End	6.59	Issue Type +	Ma	Location *	LS
Category	Earthen Levee			GPS Latitude/Longitude	
				Start	End
Item	Slope Stability			37.229682 °	37.229682 °
				-120.726305 °	-120.726305 °
DWR ID	DWR_NA0010_05_s_2015_1309				
Comment Code					
S2 : Repair the levee slope damaged by foot traffic and prevent access where possible.					
Inspector Comment					
Landside slope damage caused by animal foot traffic.

Looking north at damaged landward slope.

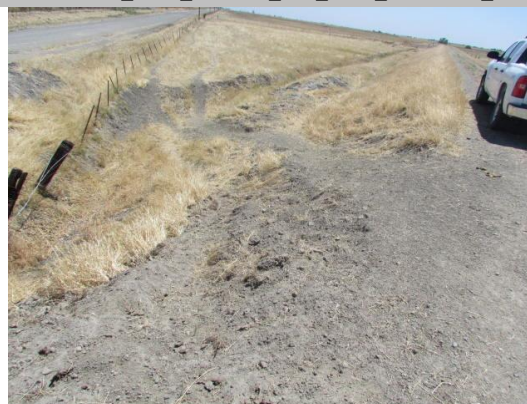
Photo 2 of 2 : SP\_2018\_NA0010\_123\_1309\_20180307\_00038.jpg

Looking east at damaged landward slope.

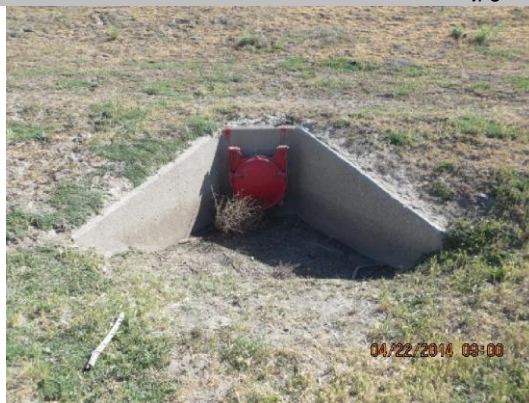
Photo 2 of 3 : UCIP\_SP\_2018\_39592\_62113.jpg

LM Start	7.36	Rating **	M	Issue No.	1327 (cont)
LM End	7.36	Issue Type +	Ma	Location *	
Category	Supplemental			GPS Latitude/Longitude	
				Start	End
Item	DWR UCIP LMA Responsibility			37.224560 °	37.224560 °
				-120.714057 °	-120.714057 °
DWR ID					
Comment Code					
Inspector Comment					
FS_ID:39592 DS_ID:19761 EP_NO: N/A Repair Type: Non-Urgent Crossing Status: Found UCIP Comments: Sediment buildup in pipe visible from landward side--recommend contacting owner to clear pipe. FIELD_STRUCT_DESC: 24-inch corrugated metal gravity drainage pipe through the levee, 12 feet below the crown. Flap gate on the waterside (WS) end. Concrete headwall on the landside (LS) end. Concrete U-shaped headwall on the waterside (WS) end. [Additional Reference(s): DWR Levee Log, 2002. USACE San Joaquin O&M Manual 601.1, 1967, (HLM 7.36)]. FS Date: 4/22/2014

Headwall, flapgate, and pipe on WS toe.

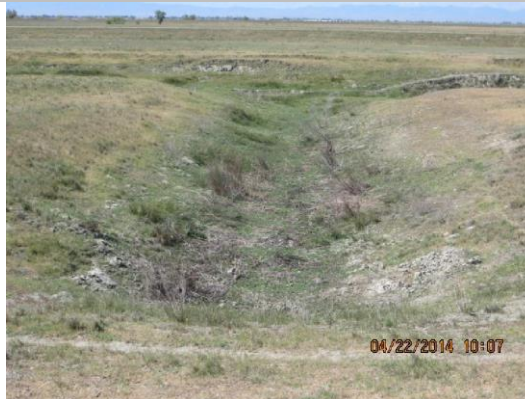
Photo 1 of 3 : UCIP\_SP\_2018\_34265\_62182.jpg

LM Start	8.46	Rating **	M	Issue No.	1329
LM End	8.46	Issue Type +	Ma	Location *	
Category	Supplemental			GPS Latitude/Longitude	
				Start	End
Item	DWR UCIP LMA Responsibility			37.209606 °	37.209606 °
				-120.702069 °	-120.702069 °
DWR ID					
Comment Code					
Inspector Comment					
FS_ID:34265					
DS_ID:19763					
EP_NO: N/A					
Repair Type: Non-Urgent					
Crossing Status: Found					
UCIP Comments: Pipe filled with silt on LS toe and should be cleared.					
FIELD_STRUCT_DESC: 24-inch corrugated metal gravity drainage pipe					
through the levee, 16 feet below the crown. Flap gate on the waterside					
(WS) end. Concrete headwall on the landside (LS) end. Concrete U-					
shaped headwall on the WS end. [Additional Reference(s): DWR Levee					
Log, 2002. USACE San Joaquin O&M Manual 601.1, 1967, (HLM 8.44)].					
FS Date: 4/22/2014

Headwall, flapgate, and pipe on WS toe

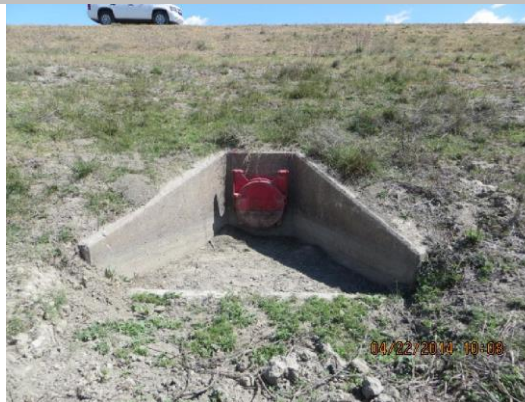
Photo 2 of 3 : UCIP\_SP\_2018\_34265\_62183.jpg

Headwall, flapgate, and pipe on WS toe

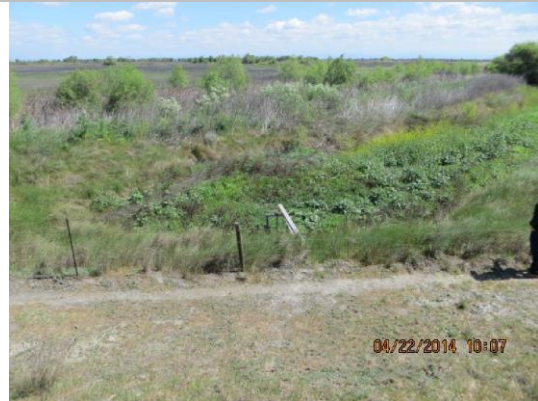
Photo 3 of 3 : UCIP\_SP\_2018\_34265\_62181.jpg

LM Start	8.46	Rating **	M	Issue No.	1329 (cont)	
LM End	8.46	Issue Type +	Ma	Location *		
Category	Supplemental			GPS Latitude/Longitude		
				Start	End	
Item	DWR UCIP LMA Responsibility			37.209606 °	37.209606 °	
				-120.702069 °	-120.702069 °	
DWR ID						
Comment Code						
Inspector Comment						
FS_ID:34265						
DS_ID:19763						
EP_NO: N/A						
Repair Type: Non-Urgent						
Crossing Status: Found						
UCIP Comments: Pipe filled with silt on LS toe and should be cleared.						
FIELD_STRUCT_DESC: 24-inch corrugated metal gravity drainage pipe						
through the levee, 16 feet below the crown. Flap gate on the waterside						
(WS) end. Concrete headwall on the landside (LS) end. Concrete U-						
shaped headwall on the WS end. [Additional Reference(s): DWR Levee						
Log, 2002. USACE San Joaquin O&M Manual 601.1, 1967, (HLM 8.44)].						
FS Date: 4/22/2014

Headwall, slidegate, and pipe on LS toe.

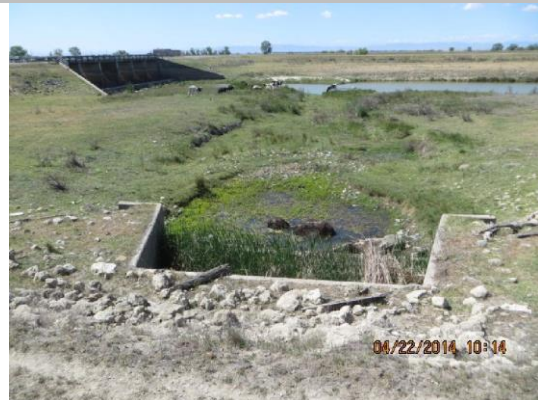
Photo 1 of 3 : UCIP\_SP\_2018\_34267\_62186.jpg

Comment Code						
Inspector Comment						
FS_ID:34267 DS_ID:19764 EP_NO: N/A Repair Type: No Action Needed Crossing Status: Found UCIP Comments: 10/27/2017 This structure is inspected annually under the Structure and Channel Summer Inspection (part of the Levee Inspection Program) conducted by the DWR Flood Project Integrity and Inspection Branch (FPIIB). (DWR UCIP - O. Magana) FIELD_STRUCT_DESC: [Deadman Creek Drainage Ditch Structure] 1 of 2: 48-inch by 102-inch reinforced concrete box gravity drainage culvert through the levee, 13.8 feet below the crown. Concrete U-shaped headwall on the waterside (WS) end. Concrete headwall on the landside (LS) end with a slide gate mounted on the headwall. WS slope and outlet drain cobble revetted. [Additional Reference(s): DWR Levee Log, 2002. USACE San Joaquin O&M Manual 601.1, 1967, (HLM 8.83)]. FS Date: 4/22/2014

Concrete headwall at outlet on WS toe.

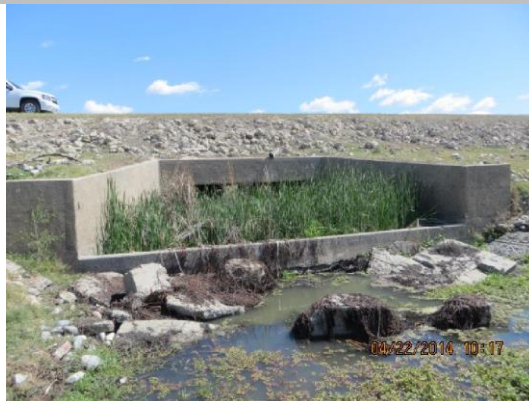
Photo 2 of 3 : UCIP\_SP\_2018\_34267\_62187.jpg

Concrete headwall at outlet on WS toe.

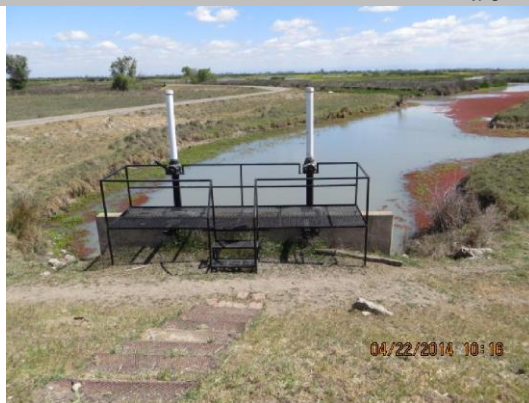
Photo 3 of 3 : UCIP\_SP\_2018\_34267\_62185.jpg

Slide gate mounted on concrete headwall at LS toe.

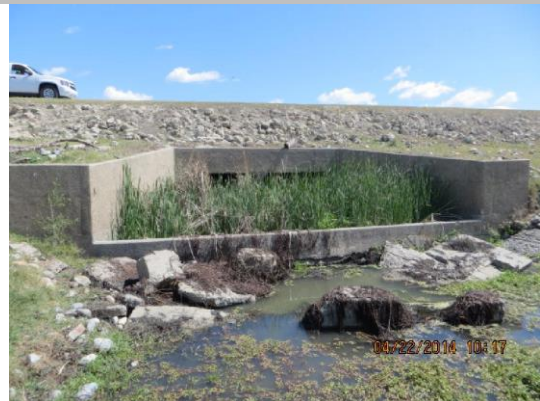
Photo 2 of 3 : UCIP\_SP\_2018\_34268\_62191.jpg

Concrete headwall on WS toe.

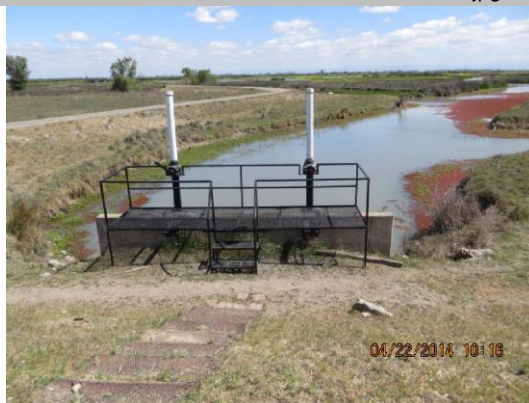
Photo 3 of 3 : UCIP\_SP\_2018\_34268\_62189.jpg

Item	DWR UCIP LMA Responsibility			37.205784 °	37.205784 °	
				-120.696843 °	-120.696843 °	
DWR ID						
Comment Code						
Inspector Comment						
FS_ID:34268 DS_ID:19735 EP_NO: N/A Repair Type: No Action Needed Crossing Status: Found UCIP Comments: 10/27/2017 This structure is inspected annually under the Structure and Channel Summer Inspection (part of the Levee Inspection Program) conducted by the DWR Flood Project Integrity and Inspection Branch (FPIIB). (DWR UCIP - O. Magana) FIELD_STRUCT_DESC: [Deadman Creek Drainage Ditch Structure] 2 of 2: 48-inch by 102-inch reinforced concrete box gravity drainage culvert through the levee, 13.8 feet below the crown. Concrete U-shaped headwall on the waterside (WS) end. Concrete headwall on the landside (LS) end with a slide gate mounted on the headwall. WS slope and outlet drain cobble revetted. [Additional Reference(s): DWR Levee Log, 2002. USACE San Joaquin O&M Manual 601.1, 1967, (HLM 8.83)]. FS Date: 4/22/2014

Slide gate mounted on concrete headwall at LS toe.

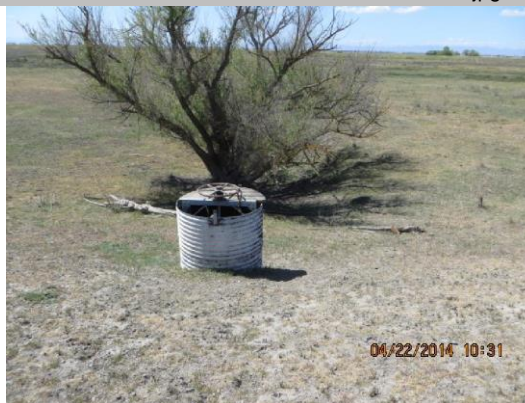
Photo 1 of 3 : UCIP\_SP\_2018\_34272\_62196.jpg

LM Start	9.28	Rating **	A/W	Issue No.	1332
LM End	9.28	Issue Type +	Ma	Location *	
Category	Supplemental			GPS Latitude/Longitude	
				Start	End
Item	DWR UCIP LMA Responsibility			37.202742 °	37.202742 °
				-120.690064 °	-120.690064 °
DWR ID					
Comment Code					
Inspector Comment					
FS_ID:34272					
DS_ID:19766					
EP_NO: N/A					
Repair Type: No Action Needed					
Crossing Status: Found					
UCIP Comments:					
FIELD_STRUCT_DESC: 36-inch corrugated metal gravity drainage pipe					
through the levee, 14.8 feet below the crown. Slide gate in a 48-inch					
corrugated metal pipe (CMP) riser on the waterside (WS) slope.					
Concrete headwall on each end. [Additional Reference(s): DWR Levee					
Log, 2002. USACE San Joaquin O&M Manual 601.1, 1967, (HLM 9.26)].					
FS Date: 4/22/2014

Slide gate in 48-inch CMP riser on WS slope.

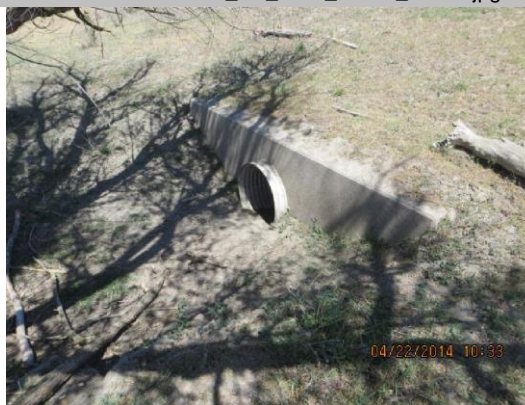
Photo 2 of 3 : UCIP\_SP\_2018\_34272\_62198.jpg

Headwall and pipe at WS toe.

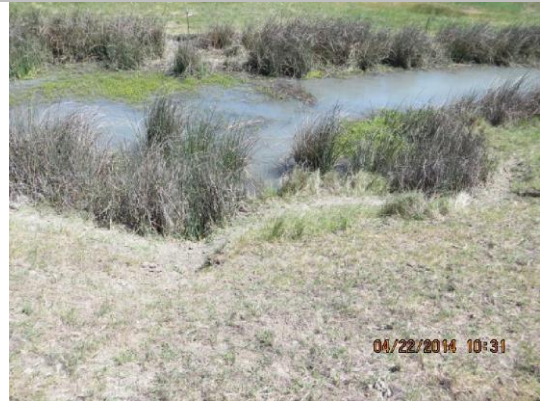
Photo 3 of 3 : UCIP\_SP\_2018\_34272\_62197.jpg

LM Start	9.28	Rating **	A/W	Issue No.	1332 (cont)	
LM End	9.28	Issue Type +	Ma	Location *		
Category	Supplemental			GPS Latitude/Longitude		
				Start	End	
Item	DWR UCIP LMA Responsibility			37.202742 °	37.202742 °	
				-120.690064 °	-120.690064 °	
DWR ID						
Comment Code						
Inspector Comment						
FS_ID:34272						
DS_ID:19766						
EP_NO: N/A						
Repair Type: No Action Needed						
Crossing Status: Found						
UCIP Comments:						
FIELD_STRUCT_DESC: 36-inch corrugated metal gravity drainage pipe						
through the levee, 14.8 feet below the crown. Slide gate in a 48-inch						
corrugated metal pipe (CMP) riser on the waterside (WS) slope.						
Concrete headwall on each end. [Additional Reference(s): DWR Levee						
Log, 2002. USACE San Joaquin O&M Manual 601.1, 1967, (HLM 9.26)].						
FS Date: 4/22/2014

Headwall and pipe at LS toe.

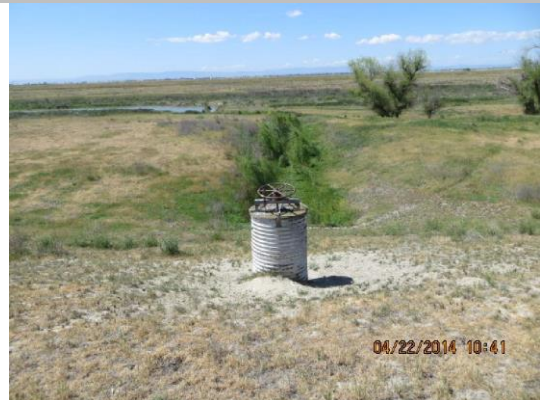
Photo 1 of 3 : UCIP\_SP\_2018\_34273\_62201.jpg

LM Start	10.06	Rating **	M	Issue No.	1333	
LM End	10.06	Issue Type +	Ma	Location *		
Category	Supplemental			GPS Latitude/Longitude		
				Start		End
Item	DWR UCIP LMA Responsibility			37.194736 °		37.194736 °
				-120.680116 °		-120.680116 °
DWR ID						
Comment Code						
Inspector Comment						
FS_ID:34273						
DS_ID:19767						
EP_NO: N/A						
Repair Type: Non-Urgent						
Crossing Status: Found						
UCIP Comments: Slidegate actuator appears bent and may not work properly (WS slope).						
FIELD_STRUCT_DESC: 24-inch corrugated metal gravity drainage pipe through the levee, 15 feet below the crown. Slide gate in a 36-inch corrugated metal pipe (CMP) riser on the waterside (WS) slope. Concrete headwall on each end. [Additional Reference(s): DWR Levee Log, 2002. USACE San Joaquin O&M Manual 601.1, 1967, (HLM 10.05)].						
FS Date: 4/22/2014

Slidegate in CMP riser on WS slope.

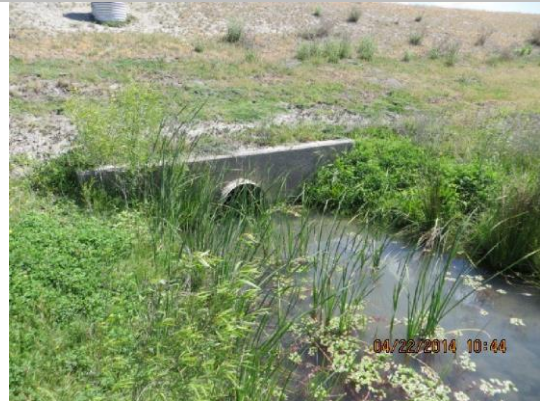
Photo 2 of 3 : UCIP\_SP\_2018\_34273\_62202.jpg

LM Start	10.06	Rating **	M	Issue No.	1333 (cont)
LM End	10.06	Issue Type +	Ma	Location *	
Category	Supplemental			GPS Latitude/Longitude	
				Start	End
Item	DWR UCIP LMA Responsibility			37.194736 °	37.194736 °
				-120.680116 °	-120.680116 °
DWR ID					
Comment Code					
Inspector Comment					
FS_ID:34273 DS_ID:19767 EP_NO: N/A Repair Type: Non-Urgent Crossing Status: Found UCIP Comments: Slidegate actuator appears bent and may not work properly (WS slope). FIELD_STRUCT_DESC: 24-inch corrugated metal gravity drainage pipe through the levee, 15 feet below the crown. Slide gate in a 36-inch corrugated metal pipe (CMP) riser on the waterside (WS) slope. Concrete headwall on each end. [Additional Reference(s): DWR Levee Log, 2002. USACE San Joaquin O&M Manual 601.1, 1967, (HLM 10.05)]. FS Date: 4/22/2014

Concrete headwall and pipe on WS toe.

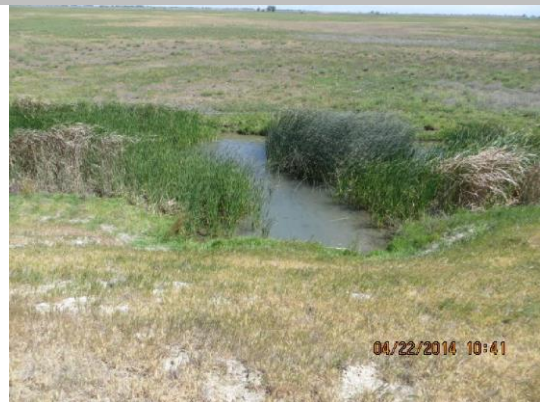
Photo 3 of 3 : UCIP\_SP\_2018\_34273\_62200.jpg

Concrete headwall and pipe on LS toe.

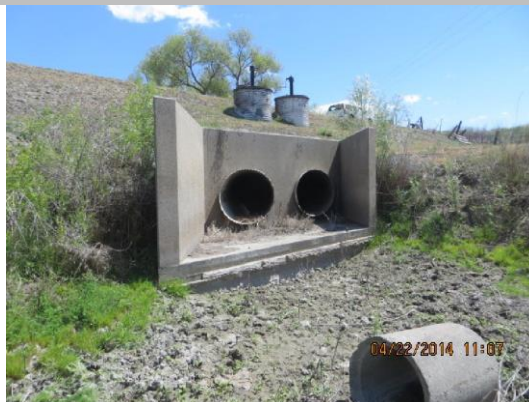
Photo 1 of 3 : UCIP\_SP\_2018\_34281\_62219.jpg

LM Start	11.49	Rating **	A/W	Issue No.	1334
LM End	11.49	Issue Type +	Ma	Location *	
Category	Supplemental			GPS Latitude/Longitude	
				Start	End
Item	DWR UCIP LMA Responsibility			37.186471 °	37.186471 °
				-120.657915 °	-120.657915 °
DWR ID					
Comment Code					
Inspector Comment					
FS_ID:34281 DS_ID:19768 EP_NO: N/A Repair Type: No Action Needed Crossing Status: Found UCIP Comments: FIELD_STRUCT_DESC: [Deadman Drainage Structure] 1 of 2: 48-inch corrugated metal gravity drainage pipe through the levee, 16 feet below the crown. Slide gate in a 60-inch corrugated metal pipe (CMP) riser on the waterside (WS) slope. Concrete U-shaped headwall on each end. Stairs on the landside (LS) slope. [Additional Reference(s): DWR Levee Log, 2002. USACE San Joaquin O&M Manual 601.1, 1967, (HLM 11.48)]. FS Date: 4/22/2014

Slidegate in CMP riser, concrete headwall and pipe visible on WS slope.

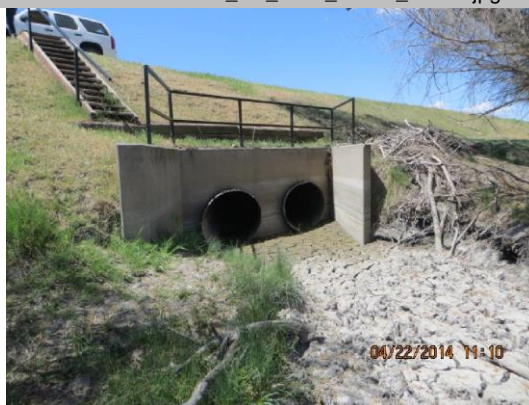
Photo 2 of 3 : UCIP\_SP\_2018\_34281\_62217.jpg

LM Start	11.49	Rating **	A/W	Issue No.	1334 (cont)	
LM End	11.49	Issue Type +	Ma	Location *		
Category	Supplemental			GPS Latitude/Longitude		
				Start		End
Item	DWR UCIP LMA Responsibility			37.186471 °	37.186471 °	
				-120.657915 °	-120.657915 °	
DWR ID						
Comment Code						
Inspector Comment						
FS_ID:34281 DS_ID:19768 EP_NO: N/A Repair Type: No Action Needed Crossing Status: Found UCIP Comments: FIELD_STRUCT_DESC: [Deadman Drainage Structure] 1 of 2: 48-inch corrugated metal gravity drainage pipe through the levee, 16 feet below the crown. Slide gate in a 60-inch corrugated metal pipe (CMP) riser on the waterside (WS) slope. Concrete U-shaped headwall on each end. Stairs on the landside (LS) slope. [Additional Reference(s): DWR Levee Log, 2002. USACE San Joaquin O&M Manual 601.1, 1967, (HLM 11.48)]. FS Date: 4/22/2014

Stairs, concrete headwall, and pipe visible on LS slope.

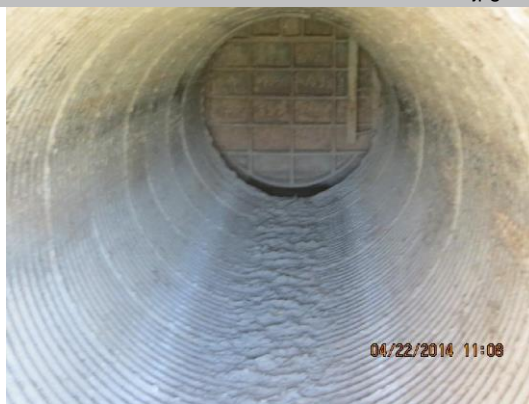
Photo 3 of 3 : UCIP\_SP\_2018\_34281\_62218.jpg

Inside pipe at LS toe.

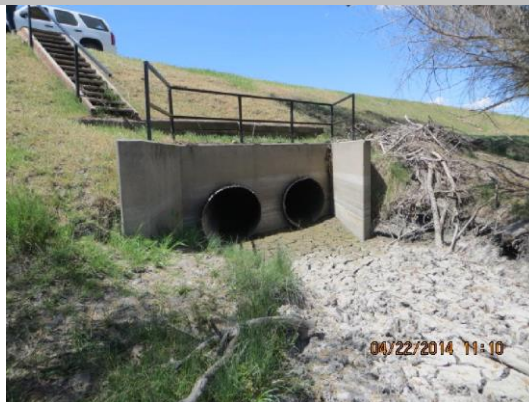
Photo 2 of 3 : UCIP\_SP\_2018\_34280\_62214.jpg

Stairs, concrete headwall and pipe on LS toe.

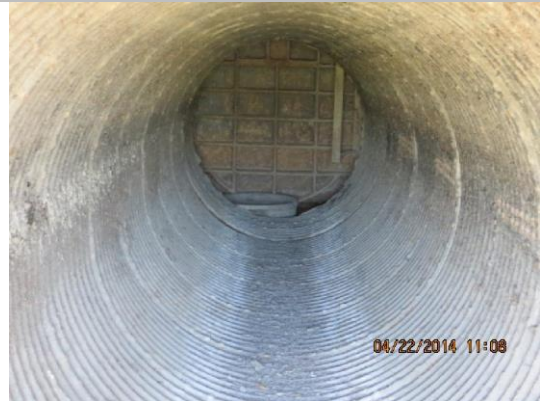
Photo 3 of 3 : UCIP\_SP\_2018\_34280\_62215.jpg

LM Start	11.50	Rating **	A/W	Issue No.	1335 (cont)
LM End	11.50	Issue Type +	Ma	Location *	
Category	Supplemental			GPS Latitude/Longitude	
				Start	End
Item	DWR UCIP LMA Responsibility			37.186458 °	37.186458 °
				-120.657903 °	-120.657903 °
DWR ID					
Comment Code					
Inspector Comment					
FS_ID:34280 DS_ID:19734 EP_NO: N/A Repair Type: No Action Needed Crossing Status: Found UCIP Comments: FIELD_STRUCT_DESC: [Deadman Drainage Structure] 2 of 2: 48-inch corrugated metal gravity drainage pipe through the levee, 16 feet below the crown. Slide gate in a 60-inch corrugated metal pipe (CMP) riser on the waterside (WS) slope. Concrete U-shaped headwall on each end. Stairs on the landside (LS) slope. [Additional Reference(s): DWR Levee Log, 2002. USACE San Joaquin O&M Manual 601.1, 1967, (HLM 11.48)]. FS Date: 4/22/2014

Inside pipe on WS toe.

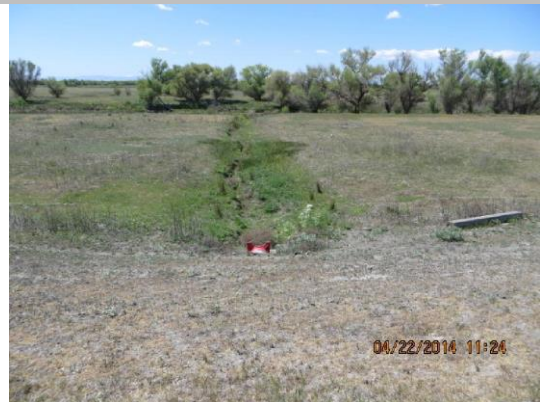
Photo 1 of 3 : UCIP\_SP\_2018\_34283\_62221.jpg

LM Start	11.65	Rating **	A/W	Issue No.	1336
LM End	11.65	Issue Type +	Ma	Location *	
Category	Supplemental			GPS Latitude/Longitude	
				Start	End
Item	DWR UCIP LMA Responsibility			37.184830 °	37.184830 °
				-120.656016 °	-120.656016 °
DWR ID					
Comment Code					
Inspector Comment					
FS_ID:34283 DS_ID:19704 EP_NO: N/A Repair Type: No Action Needed Crossing Status: Found UCIP Comments: FIELD_STRUCT_DESC: 24-inch corrugated metal gravity drainage pipe through the levee, 11.8 feet below the crown. Flap gate on the waterside (WS) end. Concrete headwall on the landside (LS) end. Concrete saddle and apron on the WS end. [Additional Reference(s): DWR Levee Log, 2002. USACE San Joaquin O&M Manual 601.1, 1967, (HLM 11.63)]. FS Date: 4/22/2014

Headwall, flapgate, and pipe at WS toe.

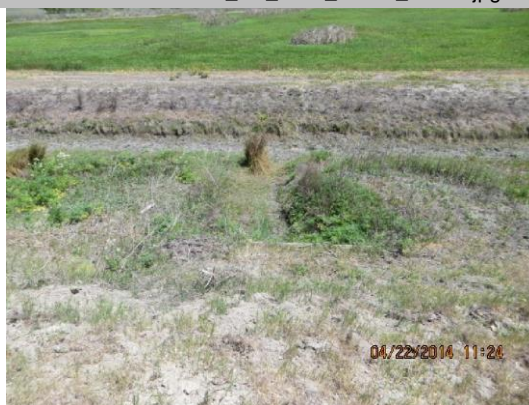
Photo 3 of 3 : UCIP\_SP\_2018\_34283\_62222.jpg

Concrete headwall and pipe at LS toe.

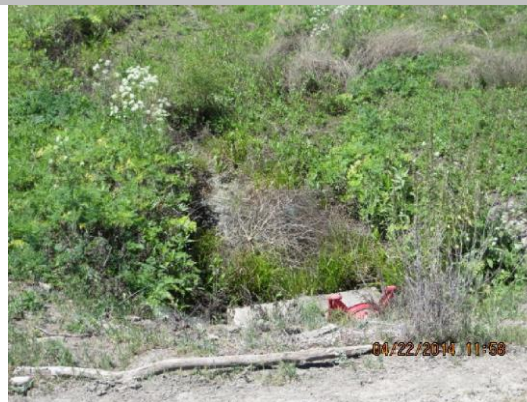
Photo 1 of 3 : UCIP\_SP\_2018\_34284\_62225.jpg

LM Start	12.01	Rating **	A/W	Issue No.	1337	
LM End	12.01	Issue Type +	Ma	Location *		
Category	Supplemental			GPS Latitude/Longitude		
				Start		End
Item	DWR UCIP LMA Responsibility			37.180291 °		37.180291 °
				-120.653931 °		-120.653931 °
DWR ID						
Comment Code						
Inspector Comment						
FS_ID:34284 DS_ID:19705 EP_NO: N/A Repair Type: No Action Needed Crossing Status: Found UCIP Comments: FIELD_STRUCT_DESC: 24-inch corrugated metal gravity drainage pipe through the levee, 12.5 feet below the crown. Flap gate on the waterside (WS) end. Concrete headwall on the landside (LS) end. Concrete saddle and apron on the waterside (WS) end. Flashboard attachment on the LS end. [Additional Reference(s): DWR Levee Log, 2002. USACE San Joaquin O&M Manual 601.1, 1967, (HLM 11.99)]. FS Date: 4/22/2014

Headwall, flapgate, and pipe on WS toe.

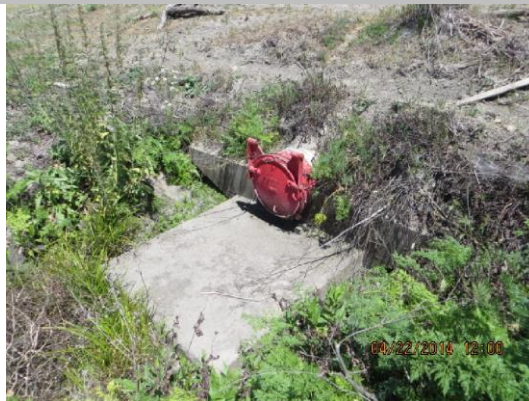
Photo 2 of 3 : UCIP\_SP\_2018\_34284\_62227.jpg

Headwall, flapgate, and pipe on WS toe.

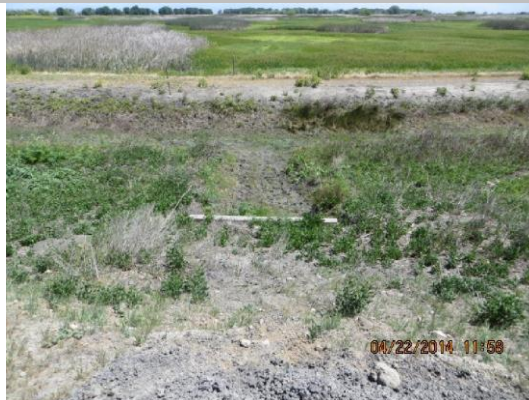
Photo 3 of 3 : UCIP\_SP\_2018\_34284\_62226.jpg

Headwall and pipe on LS toe.

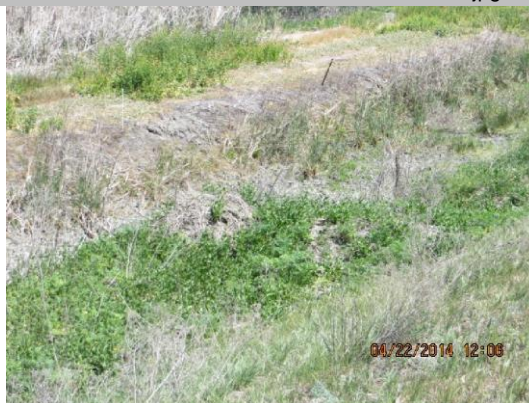
Photo 3 of 3 : UCIP\_SP\_2018\_34285\_62231.jpg

Item	DWR UCIP LMA Responsibility			37.175958 °	37.175958 °	
				-120.649798 °	-120.649798 °	
DWR ID						
Comment Code						
Inspector Comment						
FS_ID:34285						
DS_ID:19706						
EP_NO: N/A						
Repair Type: No Action Needed						
Crossing Status: Found						
UCIP Comments:						
FIELD_STRUCT_DESC: 24-inch corrugated metal gravity drainage pipe through the levee, 10.2 feet below the crown. Flap gate on the waterside (WS) end. Concrete headwall on the landside (LS) end. Concrete saddle and apron on the WS end. Flashboard attachment on the LS end. Pipe crosses levee at 45 degrees to crown alignment. [Additional Reference(s): DWR Levee Log, 2002. USACE San Joaquin O&M Manual 601.1, 1967, (HLM 12.38)].						
FS Date: 4/22/2014

Headwall and pipe on LS toe.

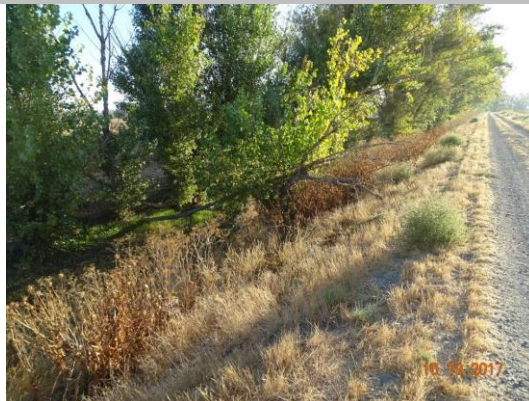
Photo 1 of 1 : SP\_2018\_NA0010\_123\_108\_20180307\_00017.jpg

LM Start	12.81	Rating **	M	Issue No.	108
LM End	12.81	Issue Type +	Ma	Location *	LS
Category	Earthen Levee			GPS Latitude/Longitude	
				Start	End
Item	Encroachments			37.175793 °	37.175793 °
				-120.642227 °	-120.642227 °
DWR ID	DWR_NA0010_05_s_2017_108				
Comment Code					
TR : Tree or limb					
Inspector Comment

Looking east at the landside slope.

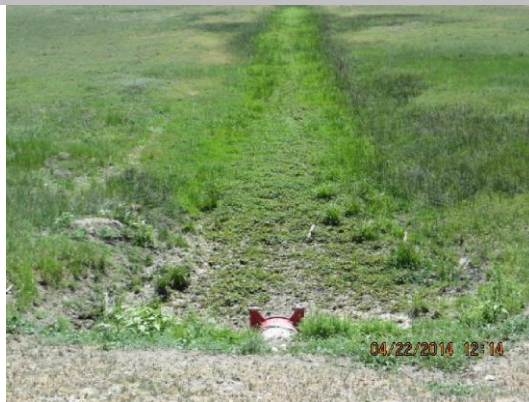
Photo 1 of 3 : UCIP\_SP\_2018\_39593\_62240.jpg

LM Start	12.89	Rating **	M	Issue No.	1339	
LM End	12.89	Issue Type +	Ma	Location *		
Category	Supplemental			GPS Latitude/Longitude		
				Start		End
Item	DWR UCIP LMA Responsibility			37.175816 °	37.175816 °	
				-120.640865 °	-120.640865 °	
DWR ID						
Comment Code						
Inspector Comment						
FS_ID:39593 DS_ID:19707 EP_NO: N/A Repair Type: Non-Urgent Crossing Status: Found UCIP Comments: Sediment buildup in pipe visible from landward side-- recommend contacting owner to clear pipe. FIELD_STRUCT_DESC: 24-inch corrugated metal gravity drainage pipe through the levee, 10.2 feet below the crown. Concrete headwall on the landside (LS) end with flashboards. Concrete saddle and apron on the waterside (WS) end with a flap gate. Metal screen at LS toe inlet. [Additional Reference(s): DWR Levee Log, 2002. USACE San Joaquin O&M Manual 601.1, 1967, (HLM 12.87)]. FS Date: 4/22/2014

Headwall, flapgate, and pipe on WS toe.

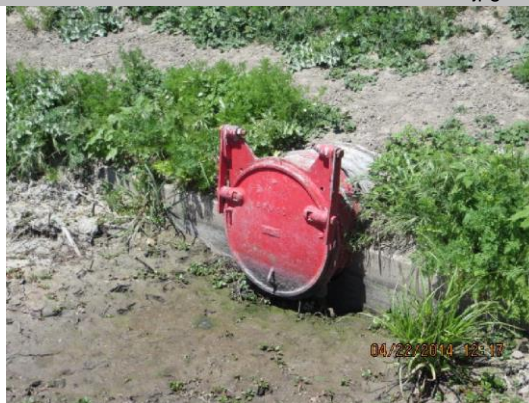
Photo 2 of 3 : UCIP\_SP\_2018\_39593\_62241.jpg

Headwall, flapgate, and pipe on WS toe.

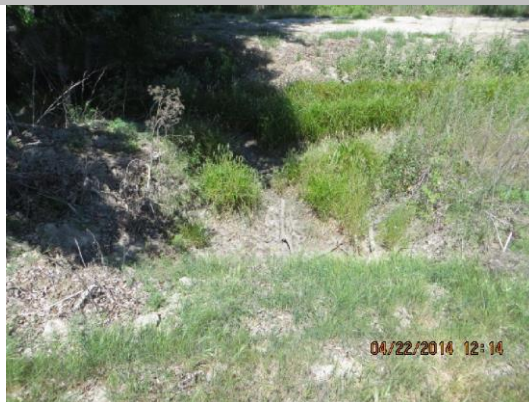
Photo 3 of 3 : UCIP\_SP\_2018\_39593\_62239.jpg

Headwall and pipe on LS toe.

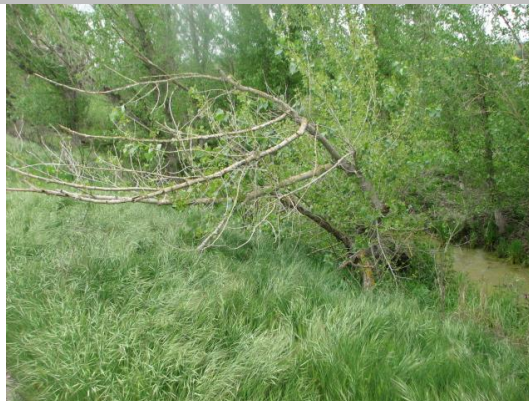
Photo 1 of 1 : SP\_2018\_NA0010\_123\_109\_20180411\_00310.jpg

LM Start	12.93	Rating **	M	Issue No.	109
LM End	12.93	Issue Type +	Ma	Location *	LS
Category	Earthen Levee			GPS Latitude/Longitude	
				Start	End
Item	Encroachments			37.175780 °	37.175780 °
				-120.640195 °	-120.640195 °
DWR ID	DWR_NA0010_05_s_2017_109				
Comment Code					
TR : Tree or limb					
Inspector Comment					
Fallen tree on landside toe.

Looking at broken tree on landward toe. (Spring 2018)

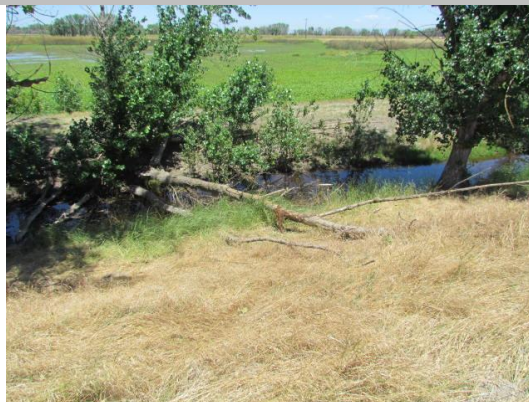
Photo 1 of 1 : SP\_2018\_NA0010\_123\_2\_20180307\_00005.jpg

LM Start	13.01	Rating **	M	Issue No.	2
LM End	13.01	Issue Type +	Ma	Location *	LS
Category	Earthen Levee			GPS Latitude/Longitude	
				Start	End
Item	Encroachments			37.175576 °	37.175576 °
				-120.638755 °	-120.638755 °
DWR ID	DWR_NA0010_05_s_2016_2				
Comment Code					
TR : Tree or limb					
Inspector Comment					
Downed tree on landside toe.

Looking west at down tree at landward toe.

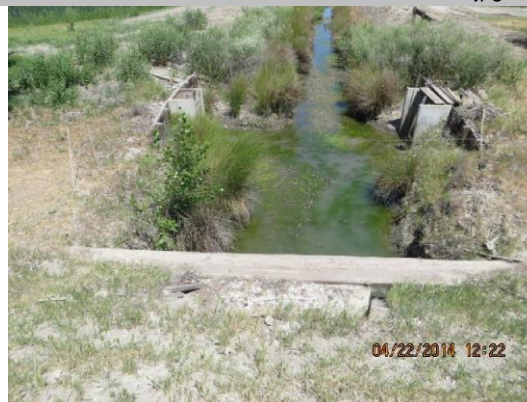
Photo 1 of 3 : UCIP\_SP\_2018\_34288\_62244.jpg

LM Start	13.42	Rating **	M	Issue No.	1340
LM End	13.42	Issue Type +	Ma	Location *	
Category	Supplemental			GPS Latitude/Longitude	
				Start	End
Item	DWR UCIP LMA Responsibility			37.171523 °	37.171523 °
				-120.633442 °	-120.633442 °
DWR ID					
Comment Code					
Inspector Comment					
FS_ID:34288 DS_ID:19708 EP_NO: N/A Repair Type: Non-Urgent Crossing Status: Found UCIP Comments: Some erosion around headwall on the WS toe and there are animal burrows on both slopes. FIELD_STRUCT_DESC: 48-inch corrugated metal gravity drainage pipe through the levee, 10 feet below the crown. Flap gate on the waterside (WS) end. Flashboard attachment in concrete U-shaped headwall on the landside (LS) end. Concrete U-shaped headwall on the WS end. [Additional Reference(s): DWR Levee Log, 2002. USACE San Joaquin O&M Manual 601.1, 1967, (HLM 13.40)]. FS Date: 4/22/2014

Headwall and pipe on LS toe.

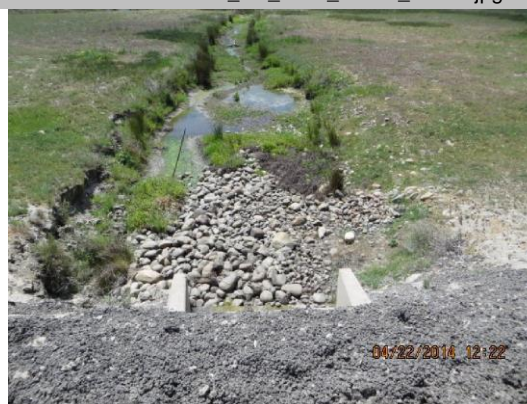
Photo 2 of 3 : UCIP\_SP\_2018\_34288\_62243.jpg

Headwall, flapgate, and pipe on WS toe.

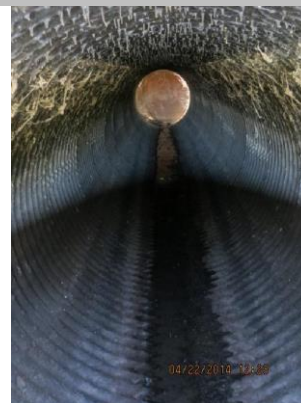
Photo 3 of 3 : UCIP\_SP\_2018\_34288\_62242.jpg

Headwall, flapgate, and pipe on WS toe.

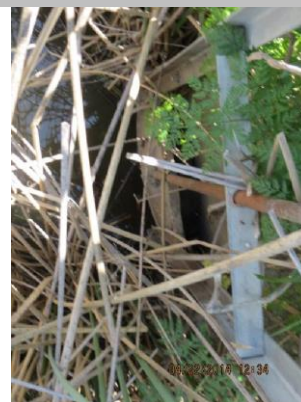
Photo 1 of 2 : UCIP\_SP\_2018\_34824\_62624.jpg

LM Start	13.72	Rating **	M	Issue No.	1341
LM End	13.72	Issue Type +	Ma	Location *	
Category	Supplemental			GPS Latitude/Longitude	
				Start	End
Item	DWR UCIP LMA Responsibility			37.168202 °	37.168202 °
				-120.629886 °	-120.629886 °
DWR ID					
Comment Code					
Inspector Comment					
FS_ID:34824 DS_ID:19709 EP_NO: N/A Repair Type: Non-Urgent Crossing Status: Found UCIP Comments: Pipe not visible and may need to have silt removed from outlet on WS toe. FIELD_STRUCT_DESC: 24-inch corrugated metal gravity drainage pipe through the levee, 16 feet below the crown. Flap gate on the waterside (WS) end. Slide gate on concrete headwall at the landside (LS) toe. Concrete saddle and apron on the WS end. [Additional Reference(s): DWR Levee Log, 2002. USACE San Joaquin O&M Manual 601.1, 1967, (HLM 13.72)]. FS Date: 4/22/2014

Slide gate at concrete headwall on LS toe.

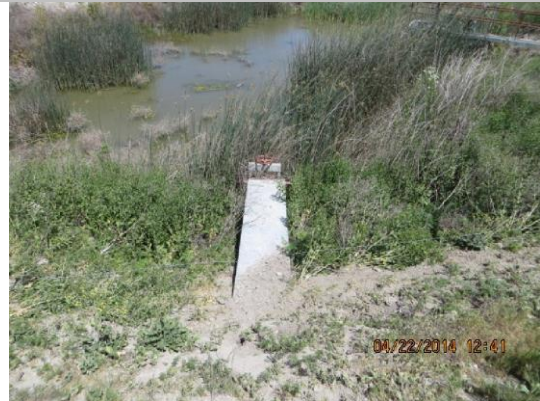
Photo 2 of 2 : UCIP\_SP\_2018\_34824\_62623.jpg

Walkway to gatevalve on LS shoulder.

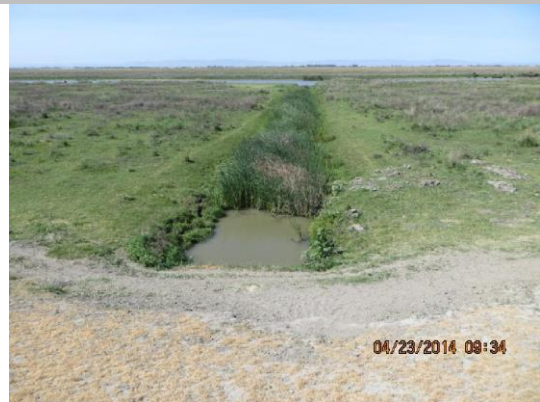
Photo 1 of 3 : UCIP\_SP\_2018\_34657\_62450.jpg

LM Start	13.85	Rating **	A/W	Issue No.	1342
LM End	13.85	Issue Type +	Ma	Location *	
Category	Supplemental			GPS Latitude/Longitude	
				Start	End
Item	DWR UCIP LMA Responsibility			37.166760 °	37.166760 °
				-120.628304 °	-120.628304 °
DWR ID					
Comment Code					
Inspector Comment					
FS_ID:34657 DS_ID:19710 EP_NO: N/A Repair Type: No Action Needed Crossing Status: Found UCIP Comments: FIELD_STRUCT_DESC: 24-inch corrugated metal gravity drainage pipe through the levee, 12.4 feet below the crown. Flap gate on the waterside (WS) end. Concrete headwall on each end. [Additional Reference(s): DWR Levee Log, 2002. USACE San Joaquin O&M Manual 601.1, 1967, (HLM 13.83)]. FS Date: 4/23/2014 4:17:00 PM

Headwall, flapgate, and pipe on WS toe.

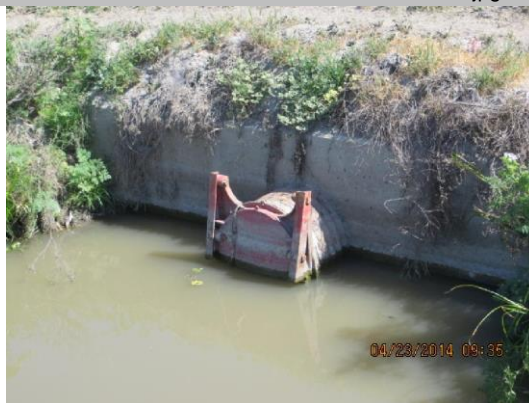
Photo 2 of 3 : UCIP\_SP\_2018\_34657\_62448.jpg

Headwall, flapgate, and pipe on WS toe.

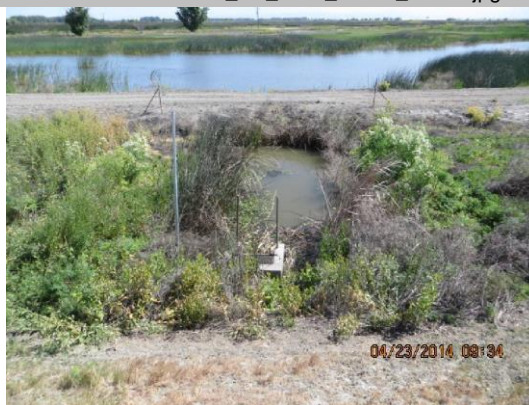
Photo 3 of 3 : UCIP\_SP\_2018\_34657\_62449.jpg

Concrete wier intake structure and pipe at LS toe.

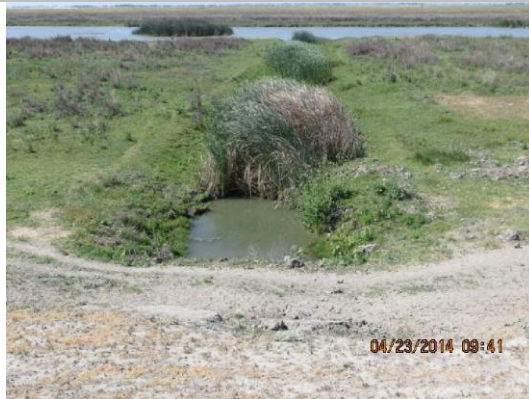
Photo 1 of 3 : UCIP\_SP\_2018\_34656\_62446.jpg

LM Start	14.46	Rating **	A/W	Issue No.	1343
LM End	14.46	Issue Type +	Ma	Location *	
Category	Supplemental			GPS Latitude/Longitude	
				Start	End
Item	DWR UCIP LMA Responsibility			37.162722 °	37.162722 °
				-120.618571 °	-120.618571 °
DWR ID					
Comment Code					
Inspector Comment					
FS_ID:34656 DS_ID:19711 EP_NO: N/A Repair Type: No Action Needed Crossing Status: Found UCIP Comments: FIELD_STRUCT_DESC: 24-inch corrugated metal gravity drainage pipe through the levee, 12.5 feet below the crown. Flap gate on the waterside (WS) end. Concrete headwall on each end. Concrete weir inlet structure on the landside (LS) toe. [Additional Reference(s): DWR Levee Log, 2002. USACE San Joaquin O&M Manual 601.1, 1967, (HLM 14.44)]. FS Date: 4/23/2014

Headwall, pipe, and flapgate on WS toe.

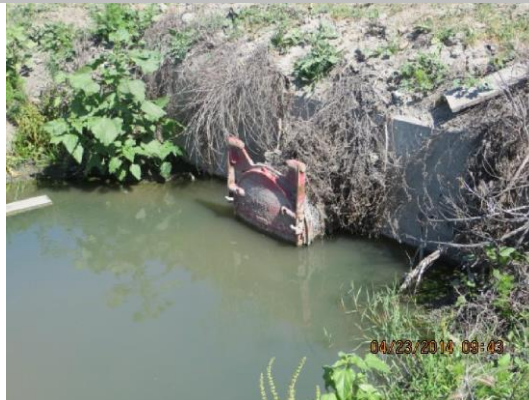
Photo 2 of 3 : UCIP\_SP\_2018\_34656\_62447.jpg

Headwall, pipe, and flapgate on WS toe.

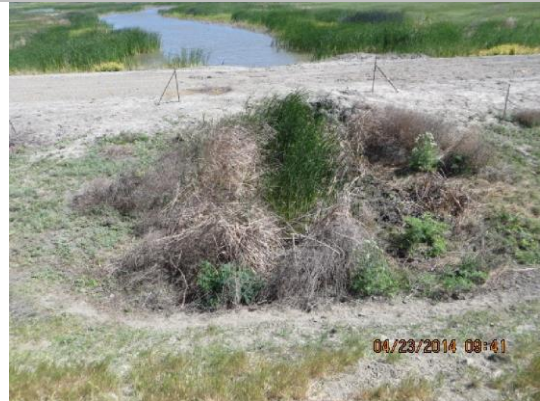
Photo 3 of 3 : UCIP\_SP\_2018\_34656\_62445.jpg

LM Start	14.46	Rating **	A/W	Issue No.	1343 (cont)	
LM End	14.46	Issue Type +	Ma	Location *		
Category	Supplemental			GPS Latitude/Longitude		
				Start	End	
Item	DWR UCIP LMA Responsibility			37.162722 °	37.162722 °	
				-120.618571 °	-120.618571 °	
DWR ID						
Comment Code						
Inspector Comment						
FS_ID:34656 DS_ID:19711 EP_NO: N/A Repair Type: No Action Needed Crossing Status: Found UCIP Comments: FIELD_STRUCT_DESC: 24-inch corrugated metal gravity drainage pipe through the levee, 12.5 feet below the crown. Flap gate on the waterside (WS) end. Concrete headwall on each end. Concrete weir inlet structure on the landside (LS) toe. [Additional Reference(s): DWR Levee Log, 2002. USACE San Joaquin O&M Manual 601.1, 1967, (HLM 14.44)]. FS Date: 4/23/2014

Concrete weir inlet at LS toe.

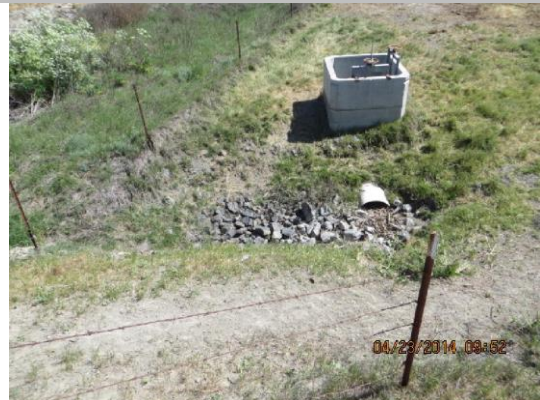
Photo 1 of 3 : UCIP\_SP\_2018\_34664\_62454.jpg

LM Start	15.11	Rating **	M	Issue No.	1344
LM End	15.11	Issue Type +	Ma	Location *	
Category	Supplemental			GPS Latitude/Longitude	
				Start	End
Item	DWR UCIP LMA Responsibility			37.156805 °	37.156805 °
				-120.609513 °	-120.609513 °
DWR ID					
Comment Code					
Inspector Comment					
FS_ID:34664					
DS_ID:19712					
EP_NO: N/A					
Repair Type: Non-Urgent					
Crossing Status: Found					
UCIP Comments: Minor erosion at headwall on WS toe.					
FIELD_STRUCT_DESC: 36-inch corrugated metal gravity drainage pipe					
through the levee, 11.9 feet below the crown. Flap gate on the					
waterside (WS) end. Concrete headwall on each end. [Additional					
Reference(s): DWR Levee Log, 2002. USACE San Joaquin O&M					
Manual 601.1, 1967, (HLM 15.09)].					
FS Date: 4/23/2014

Headwall and inlet on LS toe.

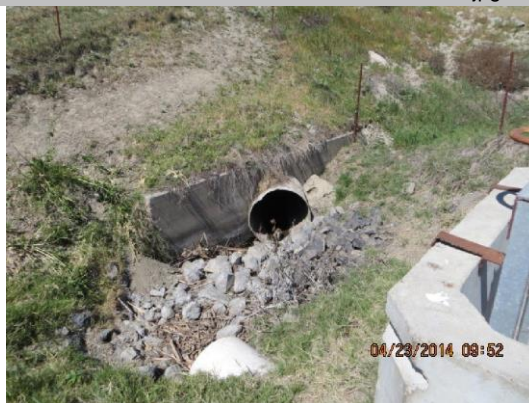
Photo 2 of 3 : UCIP\_SP\_2018\_34664\_62453.jpg

Headwall and inlet on LS toe.

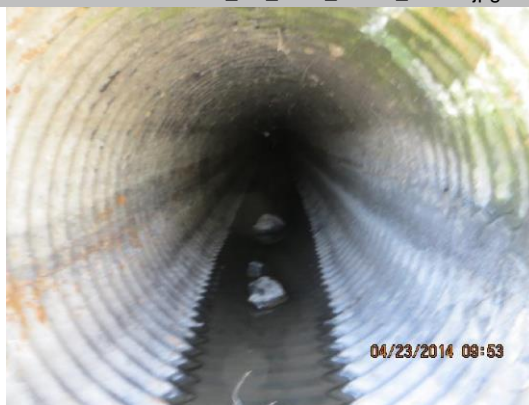
Photo 3 of 3 : UCIP\_SP\_2018\_34664\_62452.jpg

Inside pipe at LS toe.

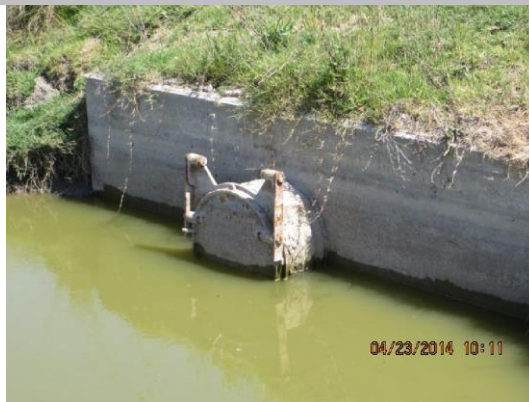
Photo 2 of 3 : UCIP\_SP\_2018\_39596\_62467.jpg

Headwall, pipe, and flapgate on WS toe.

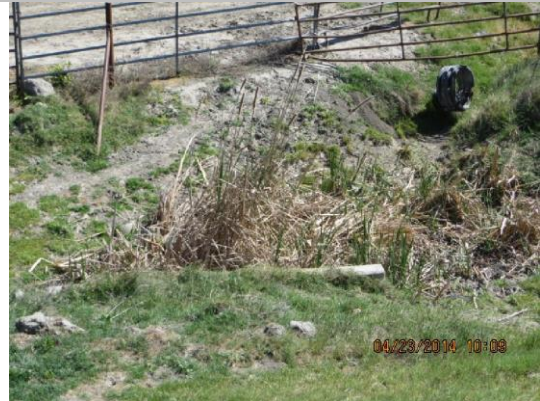
Photo 3 of 3 : UCIP\_SP\_2018\_39596\_62466.jpg

Headwall and pipe visible at LS toe.

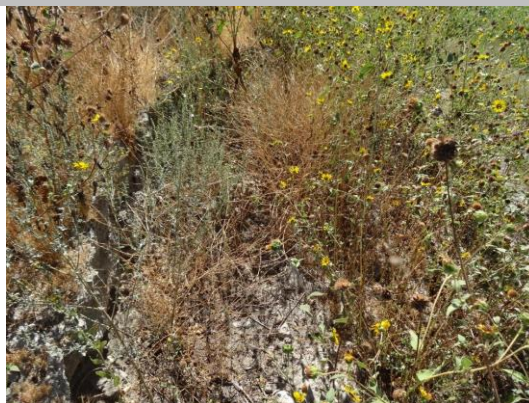
Photo 2 of 4 : SP\_2018\_NA0010\_123\_1\_20180307\_00002.jpg

LM Start	16.11	Rating **	M	Issue No.	1
LM End	16.12	Issue Type +	Ma	Location *	WS
Category	Supplemental			GPS Latitude/Longitude	
				Start	End
Item	DWR Erosion Survey			37.145965 °	37.145965 °
				-120.597597 °	-120.597597 °
DWR ID	NA0010U05RM13.85				
Comment Code					
Inspector Comment					
09/20/2017: The erosion was discovered during spring levee inspection. The site is covered by dense vegetation and the measurements of the erosion are estimated. [2017 Site ID:NA0010U05RM13.85]

Close view of the erosion.

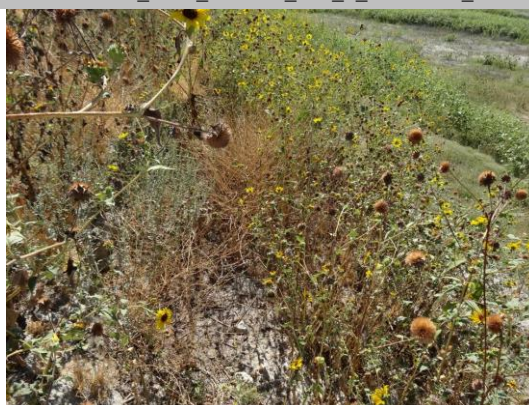
Photo 3 of 4 : SP\_2018\_NA0010\_123\_1\_20180307\_00003.jpg

Close view of the erosion.
