**Flood Control Project Maintenance  
Levee Inspections**

## Maintenance Issue Types Only, Levee Inspection Report By Mile - Spring 2018

### Lower San Joaquin Levee District

Waterway	Bank	Unit Miles	Inspection Start/End	Inspector
Unit No. 01 San Joaquin River	Right	22.52	04/04/2018 04/16/2018	Richard Willoughby

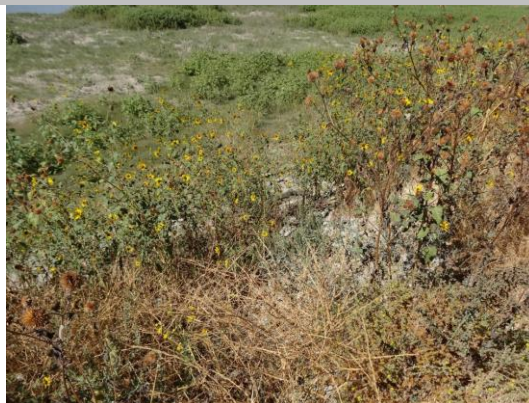
Photo 4 of 4 : SP\_2018\_NA0010\_123\_1\_20180307\_00004.jpg

Looking down at the erosion.

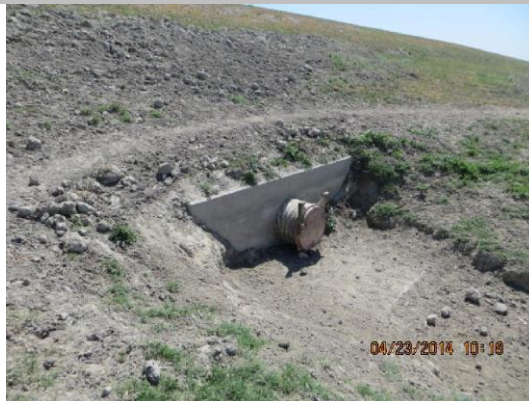
Photo 2 of 3 : UCIP\_SP\_2018\_34725\_62471.jpg

Headwall, flapgate, and pipe visible on WS toe.

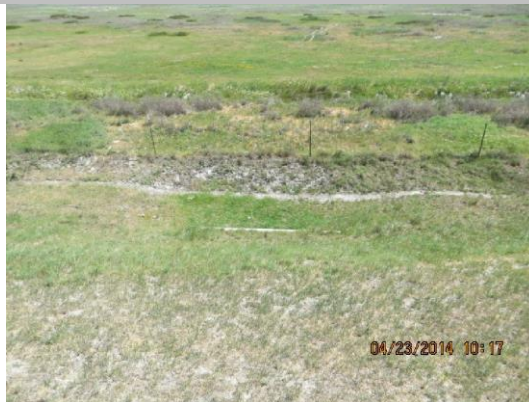
Photo 3 of 3 : UCIP\_SP\_2018\_34725\_62470.jpg

Concrete headwall and pipe visible on LS toe.

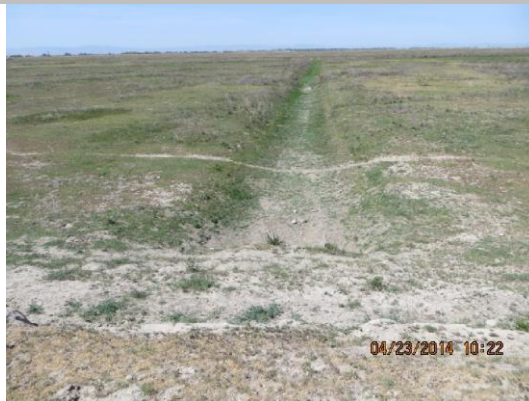
Photo 1 of 3 : UCIP\_SP\_2018\_39597\_62481.jpg

Headwall, flapgate, and pipe visible on WS toe.

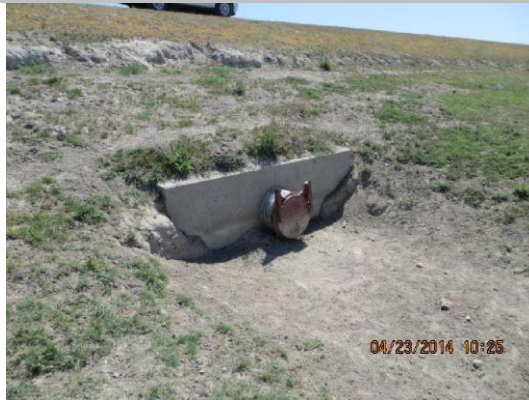
Photo 2 of 3 : UCIP\_SP\_2018\_39597\_62483.jpg

Headwall, flapgate, and pipe visible on WS toe.

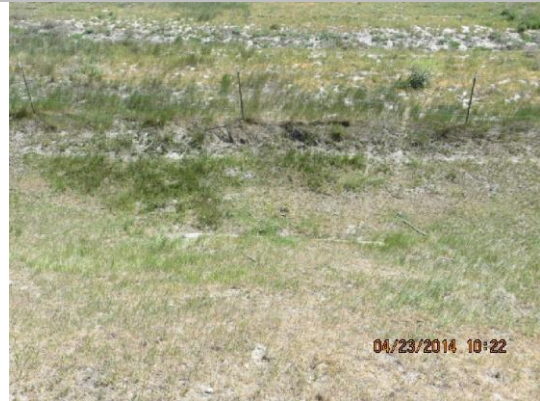
Photo 3 of 3 : UCIP\_SP\_2018\_39597\_62482.jpg

Headwall and pipe visible on LS toe.

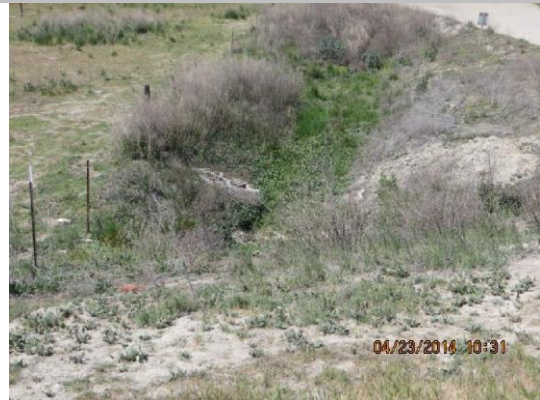
Photo 1 of 3 : UCIP\_SP\_2018\_39599\_62485.jpg

LM Start	17.54	Rating **	M	Issue No.	1349
LM End	17.54	Issue Type +	Ma	Location *	
Category	Supplemental			GPS Latitude/Longitude	
				Start	End
Item	DWR UCIP LMA Responsibility			37.127843 °	37.127843 °
				-120.585245 °	-120.585245 °
DWR ID					
Comment Code					
Inspector Comment					
FS_ID:39599 DS_ID:19743 EP_NO: N/A Repair Type: Non-Urgent Crossing Status: Found UCIP Comments: Sediment buildup in pipe visible from landward side--recommend contacting owner to clear pipe. FIELD_STRUCT_DESC: 24-inch corrugated metal gravity drainage pipe through the levee, 9.8 feet below the crown. Flap gate on the waterside (WS) end. Concrete headwall on each end. [Additional Reference(s): DWR Levee Log, 2002. USACE San Joaquin O&M Manual 601.1, 1967, (HLM 17.52)]. FS Date: 4/23/2014

Headwall, pipe, and flapgate visible on WS toe.

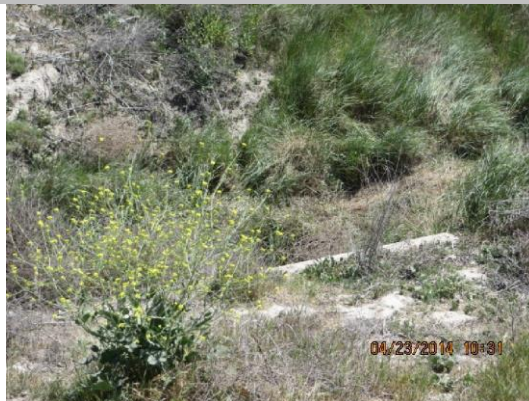
Photo 2 of 3 : UCIP\_SP\_2018\_39599\_62486.jpg

Pipe and headwall visible on LS toe.

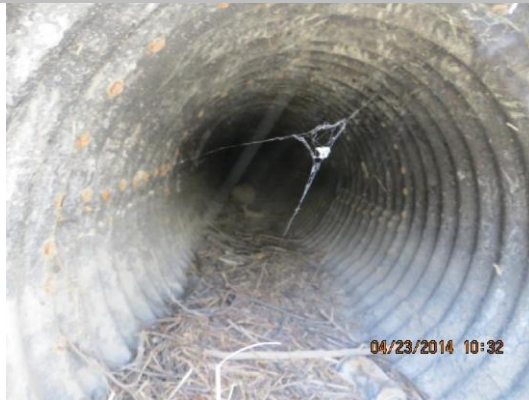
Photo 3 of 3 : UCIP\_SP\_2018\_39599\_62488.jpg

Inside pipe on LS toe.

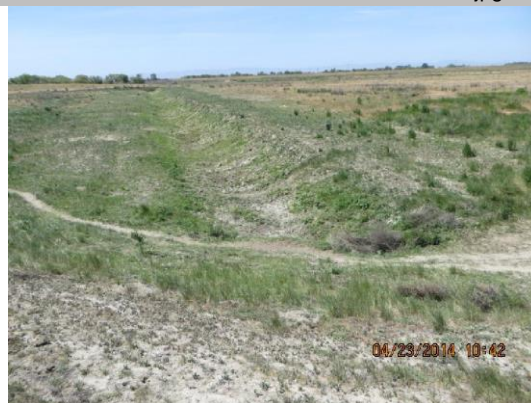
Photo 1 of 3 : UCIP\_SP\_2018\_34747\_62494.jpg

LM Start	18.09	Rating **	M	Issue No.	1350
LM End	18.09	Issue Type +	Ma	Location *	
Category	Supplemental			GPS Latitude/Longitude	
				Start	End
Item	DWR UCIP LMA Responsibility			37.120309 °	37.120309 °
				-120.582041 °	-120.582041 °
DWR ID					
Comment Code					
Inspector Comment					
FS_ID:34747					
DS_ID:19745					
EP_NO: N/A					
Repair Type: Non-Urgent					
Crossing Status: Found					
UCIP Comments: Animal burrows in levee on both slopes.					
FIELD_STRUCT_DESC: 24-inch corrugated metal gravity drainage pipe					
through the levee, 12.4 feet below the crown. Flap gate on the					
waterside (WS) end. Concrete headwall on each end. [Additional					
Reference(s): DWR Levee Log, 2002. USACE San Joaquin O&M					
Manual 601.1, 1967, (HLM 18.07)].					
FS Date: 4/23/2014

Headwall, pipe, and flapgate on WS toe.

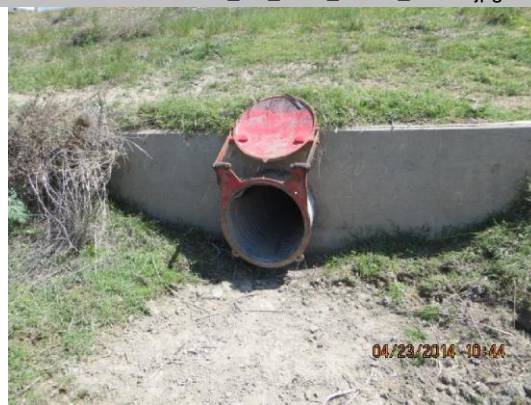
Photo 2 of 3 : UCIP\_SP\_2018\_34747\_62495.jpg

Headwall, pipe, and flapgate on WS toe.

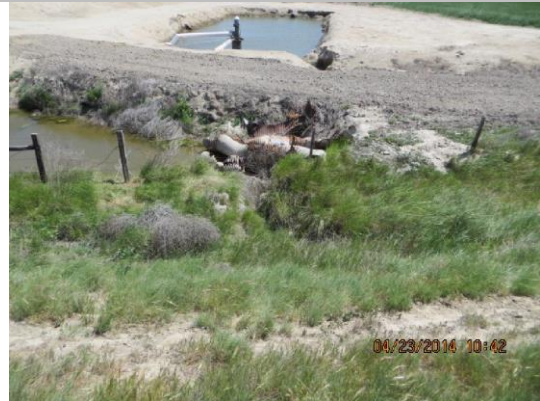
Photo 3 of 3 : UCIP\_SP\_2018\_34747\_62493.jpg

Headwall and pipe visible on LS toe.

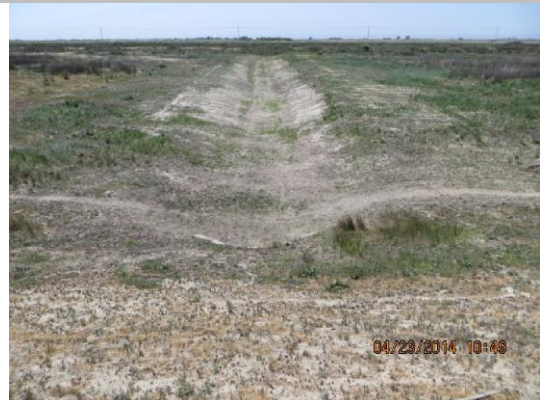
Photo 1 of 3 : UCIP\_SP\_2018\_39600\_62499.jpg

Comment Code					
Inspector Comment					
FS_ID:39600					
DS_ID:19746					
EP_NO: N/A					
Repair Type: Non-Urgent					
Crossing Status: Found					
UCIP Comments: Dense vegetation limits the inspector's visibility to identify signs of pipe failure (leaks) along the landward slope.					
Recommend removing vegetation along pipe alignment to conduct proper inspection of structure.					
FIELD_STRUCT_DESC: 24-inch corrugated metal gravity drainage pipe through the levee, 10 feet below the crown. Flap gate on the waterside (WS) end. Concrete headwall on the landside (LS) end. Concrete U-shaped headwall on the WS end. [Additional Reference(s): DWR Levee Log, 2002. USACE San Joaquin O&M Manual 601.1, 1967, (HLM 18.68)].					
FS Date: 4/23/2014

Headwall, pipe and flapgate visible on WS toe.

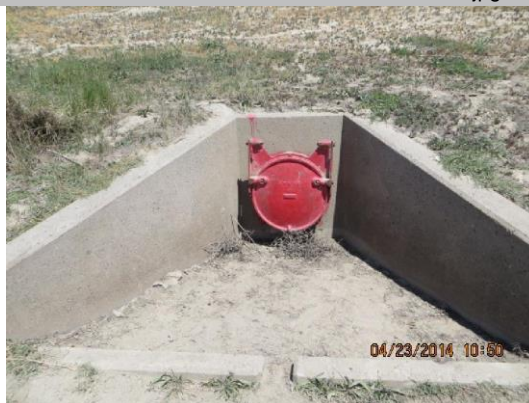
Photo 2 of 3 : UCIP\_SP\_2018\_39600\_62498.jpg

Comment Code					
Inspector Comment					
FS_ID:39600 DS_ID:19746 EP_NO: N/A Repair Type: Non-Urgent Crossing Status: Found UCIP Comments: Dense vegetation limits the inspector's visibility to identify signs of pipe failure (leaks) along the landward slope. Recommend removing vegetation along pipe alignment to conduct proper inspection of structure. FIELD_STRUCT_DESC: 24-inch corrugated metal gravity drainage pipe through the levee, 10 feet below the crown. Flap gate on the waterside (WS) end. Concrete headwall on the landside (LS) end. Concrete U-shaped headwall on the WS end. [Additional Reference(s): DWR Levee Log, 2002. USACE San Joaquin O&M Manual 601.1, 1967, (HLM 18.68)]. FS Date: 4/23/2014

Headwall, pipe and flapgate visible on WS toe.

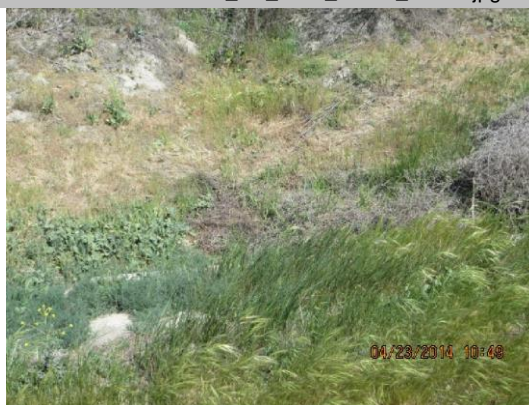
Photo 3 of 3 : UCIP\_SP\_2018\_39600\_62500.jpg

Headwall and pipe on LS toe.

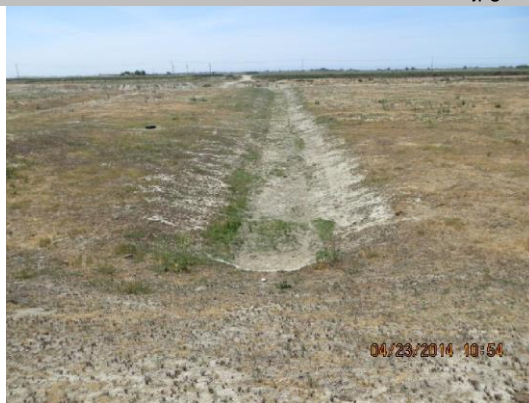
Photo 1 of 3 : UCIP\_SP\_2018\_39601\_62504.jpg

LM Start	19.15	Rating **	M	Issue No.	1352
LM End	19.15	Issue Type +	Ma	Location *	
Category	Supplemental			GPS Latitude/Longitude	
				Start	End
Item	DWR UCIP LMA Responsibility			37.115466 °	37.115466 °
				-120.565467 °	-120.565467 °
DWR ID					
Comment Code					
Inspector Comment					
FS_ID:39601 DS_ID:19747 EP_NO: N/A Repair Type: Non-Urgent Crossing Status: Found UCIP Comments: Sediment buildup in pipe visible from landward side--recommend contacting owner to clear pipe. FIELD_STRUCT_DESC: 24-inch corrugated metal gravity drainage pipe through the levee, 10 feet below the crown. Flap gate on the waterside (WS) end. Concrete headwall on the landside (LS) end. Concrete U-shaped headwall on the WS end. [Additional Reference(s): DWR Levee Log, 2002. USACE San Joaquin O&M Manual 601.1, 1967, (HLM 19.11)]. FS Date: 4/23/2014

Headwall, pipe, and flapgate visible on WS toe.

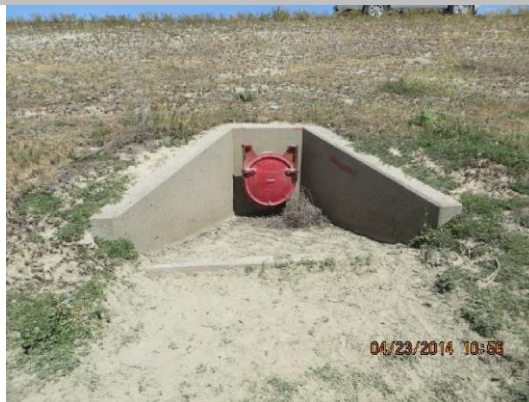
Photo 2 of 3 : UCIP\_SP\_2018\_39601\_62506.jpg

Headwall, pipe, and flapgate visible on WS toe.

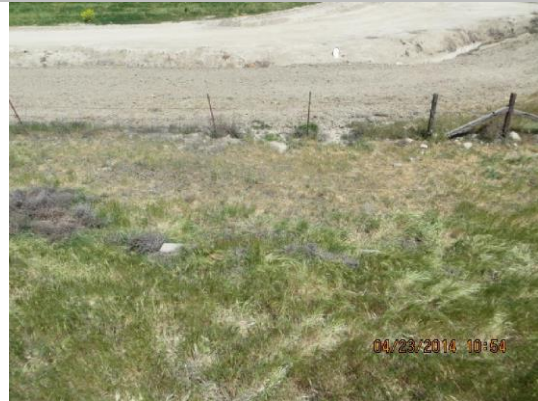
Photo 3 of 3 : UCIP\_SP\_2018\_39601\_62505.jpg

LM Start	19.15	Rating **	M	Issue No.	1352 (cont)
LM End	19.15	Issue Type +	Ma	Location *	
Category	Supplemental			GPS Latitude/Longitude	
				Start	End
Item	DWR UCIP LMA Responsibility			37.115466 °	37.115466 °
				-120.565467 °	-120.565467 °
DWR ID					
Comment Code					
Inspector Comment					
FS_ID:39601 DS_ID:19747 EP_NO: N/A Repair Type: Non-Urgent Crossing Status: Found UCIP Comments: Sediment buildup in pipe visible from landward side-- recommend contacting owner to clear pipe. FIELD_STRUCT_DESC: 24-inch corrugated metal gravity drainage pipe through the levee, 10 feet below the crown. Flap gate on the waterside (WS) end. Concrete headwall on the landside (LS) end. Concrete U-shaped headwall on the WS end. [Additional Reference(s): DWR Levee Log, 2002. USACE San Joaquin O&M Manual 601.1, 1967, (HLM 19.11)]. FS Date: 4/23/2014

Headwall and pipe visible on LS toe.

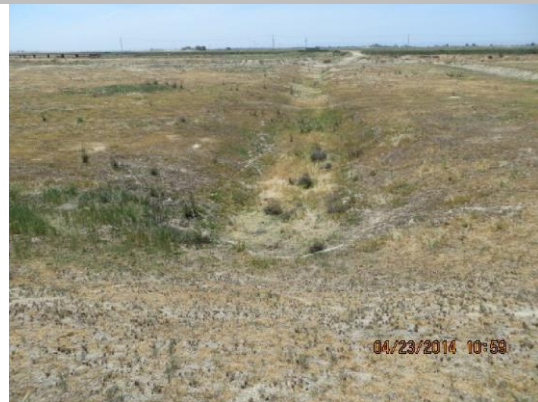
Photo 1 of 3 : UCIP\_SP\_2018\_34751\_62509.jpg

LM Start	19.17	Rating **	A/W	Issue No.	1353
LM End	19.17	Issue Type +	Ma	Location *	
Category	Supplemental			GPS Latitude/Longitude	
				Start	End
Item	DWR UCIP LMA Responsibility			37.115463 °	37.115463 °
				-120.565086 °	-120.565086 °
DWR ID					
Comment Code					
Inspector Comment					
FS_ID:34751					
DS_ID:19776					
EP_NO: N/A					
Repair Type: No Action Needed					
Crossing Status: Found					
UCIP Comments:					
FIELD_STRUCT_DESC: 24-inch corrugated metal gravity drainage pipe through the levee, 10.3 feet below the crown. Flap gate on the waterside (WS) end. Concrete headwall on the landside (LS) end. Concrete U-shaped headwall on the WS end. [Additional Reference(s): DWR Levee Log, 2002. USACE San Joaquin O&M Manual 601.1, 1967, (HLM 19.15)].					
FS Date: 4/23/2014

Headwall, pipe, and flapgate visible on WS toe.

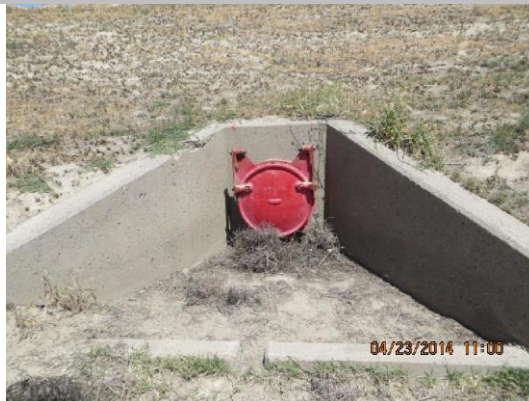
Photo 2 of 3 : UCIP\_SP\_2018\_34751\_62511.jpg

LM Start	19.17	Rating **	A/W	Issue No.	1353 (cont)
LM End	19.17	Issue Type +	Ma	Location *	
Category	Supplemental			GPS Latitude/Longitude	
				Start	End
Item	DWR UCIP LMA Responsibility			37.115463 °	37.115463 °
				-120.565086 °	-120.565086 °
DWR ID					
Comment Code					
Inspector Comment					
FS_ID:34751 DS_ID:19776 EP_NO: N/A Repair Type: No Action Needed Crossing Status: Found UCIP Comments: FIELD_STRUCT_DESC: 24-inch corrugated metal gravity drainage pipe through the levee, 10.3 feet below the crown. Flap gate on the waterside (WS) end. Concrete headwall on the landside (LS) end. Concrete U-shaped headwall on the WS end. [Additional Reference(s): DWR Levee Log, 2002. USACE San Joaquin O&M Manual 601.1, 1967, (HLM 19.15)]. FS Date: 4/23/2014

Headwall, pipe, and flapgate visible on WS toe.

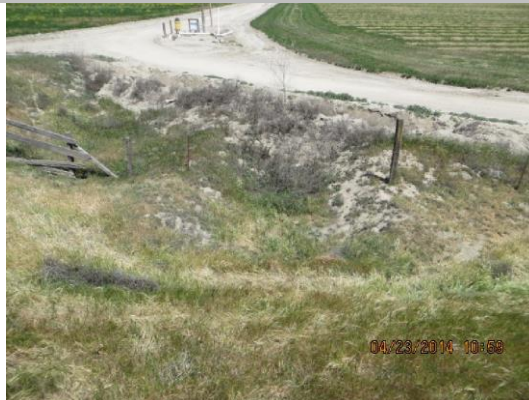
Photo 3 of 3 : UCIP\_SP\_2018\_34751\_62510.jpg

Headwall and pipe visible on LS toe.

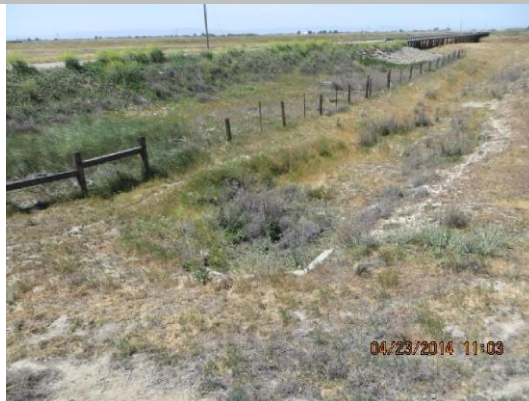
Photo 1 of 3 : UCIP\_SP\_2018\_39602\_62514.jpg

LM Start	19.48	Rating **	M	Issue No.	1354	
LM End	19.48	Issue Type +	Ma	Location *		
Category	Supplemental			GPS Latitude/Longitude		
				Start		End
Item	DWR UCIP LMA Responsibility			37.113542 °		37.113542 °
				-120.560389 °		-120.560389 °
DWR ID						
Comment Code						
Inspector Comment						
FS_ID:39602 DS_ID:19777 EP_NO: N/A Repair Type: Non-Urgent Crossing Status: Found UCIP Comments: Sediment buildup in pipe visible from landward side--recommend contacting owner to clear pipe. FIELD_STRUCT_DESC: 24-inch corrugated metal gravity drainage pipe through the levee, 9 feet below the crown. Flap gate on the waterside (WS) end. Concrete headwall on the landside (LS) end. Concrete U-shaped headwall on the WS end. [Additional Reference(s): DWR Levee Log, 2002. USACE San Joaquin O&M Manual 601.1, 1967, (HLM 19.46)]. FS Date: 4/23/2014

Headwall, pipe, and flapgate visible on WS toe.

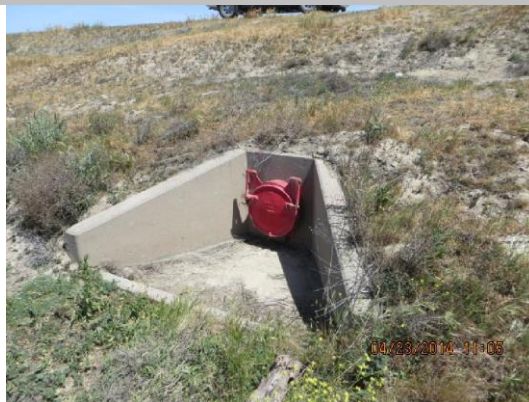
Photo 2 of 3 : UCIP\_SP\_2018\_39602\_62516.jpg

Headwall, pipe, and flapgate visible on WS toe.

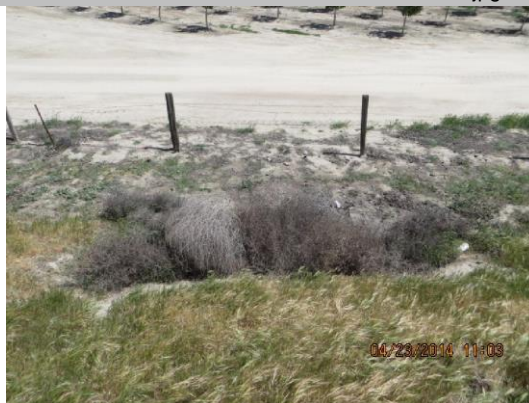
Photo 3 of 3 : UCIP\_SP\_2018\_39602\_62515.jpg

LM Start	19.48	Rating **	M	Issue No.	1354 (cont)	
LM End	19.48	Issue Type +	Ma	Location *		
Category	Supplemental			GPS Latitude/Longitude		
				Start		End
Item	DWR UCIP LMA Responsibility			37.113542 °	37.113542 °	
				-120.560389 °	-120.560389 °	
DWR ID						
Comment Code						
Inspector Comment						
FS_ID:39602						
DS_ID:19777						
EP_NO: N/A						
Repair Type: Non-Urgent						
Crossing Status: Found						
UCIP Comments: Sediment buildup in pipe visible from landward side--recommend contacting owner to clear pipe.						
FIELD_STRUCT_DESC: 24-inch corrugated metal gravity drainage pipe through the levee, 9 feet below the crown. Flap gate on the waterside (WS) end. Concrete headwall on the landside (LS) end. Concrete U-shaped headwall on the WS end. [Additional Reference(s): DWR Levee Log, 2002. USACE San Joaquin O&M Manual 601.1, 1967, (HLM 19.46)].						
FS Date: 4/23/2014

Headwall and pipe visible on LS toe.

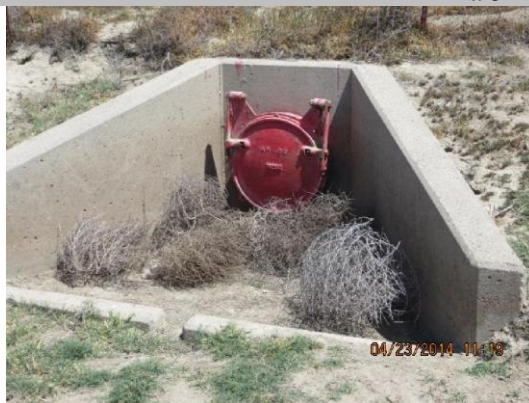
Photo 2 of 3 : UCIP\_SP\_2018\_39603\_62521.jpg

FS\_ID:39603  
DS\_ID:19778  
EP\_NO: N/A  
Repair Type: Non-Urgent  
Crossing Status: Found  
UCIP Comments: Dense vegetation limits the inspector's visibility to identify signs of pipe failure (leaks) along the landward slope. Recommend removing vegetation along pipe alignment to conduct proper inspection of structure. Sediment buildup in pipe visible from landward side--recommend contacting owner to clear pipe.  
FIELD\_STRUCT\_DESC: 24-inch corrugated metal gravity drainage pipe through the levee, 9.7 feet below the crown. Flap gate on the waterside (WS) end. Concrete headwall on the landside (LS) end. Concrete U-shaped headwall on the WS end. [Additional Reference(s): DWR Levee Log, 2002. USACE San Joaquin O&M Manual 601.1, 1967, (HLM 19.50)].  
FS Date: 4/23/2014

Headwall, pipe, and flapgate visible on WS toe.

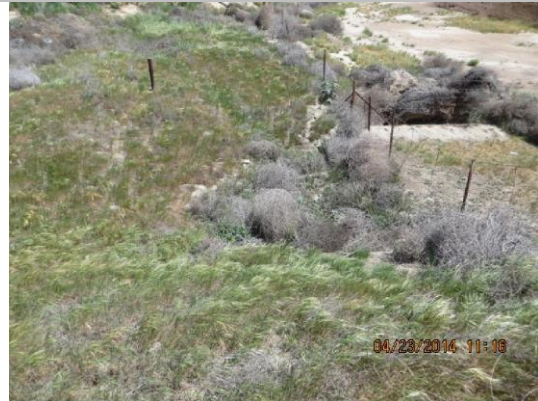
Photo 3 of 3 : UCIP\_SP\_2018\_39603\_62520.jpg

Item	DWR UCIP LMA Responsibility			37.112953 °	37.112953 °	
				-120.559943 °	-120.559943 °	
DWR ID						
Comment Code						
Inspector Comment						
FS_ID:39603 DS_ID:19778 EP_NO: N/A Repair Type: Non-Urgent Crossing Status: Found UCIP Comments: Dense vegetation limits the inspector's visibility to identify signs of pipe failure (leaks) along the landward slope. Recommend removing vegetation along pipe alignment to conduct proper inspection of structure. Sediment buildup in pipe visible from landward side--recommend contacting owner to clear pipe. FIELD_STRUCT_DESC: 24-inch corrugated metal gravity drainage pipe through the levee, 9.7 feet below the crown. Flap gate on the waterside (WS) end. Concrete headwall on the landside (LS) end. Concrete U-shaped headwall on the WS end. [Additional Reference(s): DWR Levee Log, 2002. USACE San Joaquin O&M Manual 601.1, 1967, (HLM 19.50)]. FS Date: 4/23/2014

Headwall and pipe visible on LS toe.

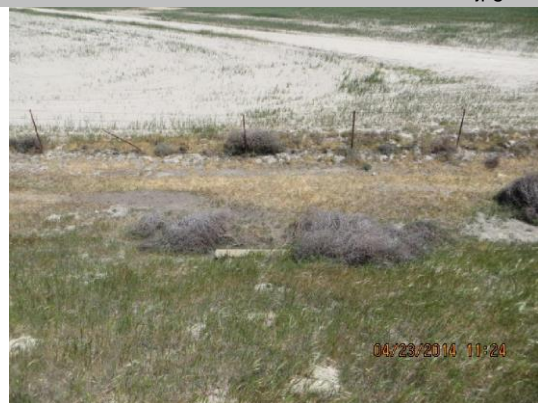
Photo 1 of 3 : UCIP\_SP\_2018\_34754\_62525.jpg

LM Start	19.86	Rating **	A/W	Issue No.	1357
LM End	19.86	Issue Type +	Ma	Location *	
Category	Supplemental			GPS Latitude/Longitude	
				Start	End
Item	DWR UCIP LMA Responsibility			37.109284 °	37.109284 °
				-120.555948 °	-120.555948 °
DWR ID					
Comment Code					
Inspector Comment					
FS_ID:34754 DS_ID:19779 EP_NO: N/A Repair Type: No Action Needed Crossing Status: Found UCIP Comments: FIELD_STRUCT_DESC: 24-inch corrugated metal gravity drainage pipe through the levee, 10.3 feet below the crown. Flap gate on the waterside (WS) end. Concrete headwall on the landside (LS) end. Concrete U-shaped headwall on the WS end. [Additional Reference(s): DWR Levee Log, 2002. USACE San Joaquin O&M Manual 601.1, 1967, (HLM 19.84)]. FS Date: 4/23/2014

Headwall and pipe visible on LS toe.

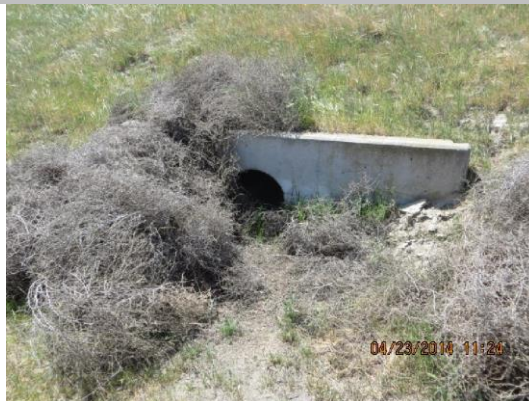
Photo 2 of 3 : UCIP\_SP\_2018\_34754\_62524.jpg

LM Start	19.86	Rating **	A/W	Issue No.	1357 (cont)
LM End	19.86	Issue Type +	Ma	Location *	
Category	Supplemental			GPS Latitude/Longitude	
				Start	End
Item	DWR UCIP LMA Responsibility			37.109284 °	37.109284 °
				-120.555948 °	-120.555948 °
DWR ID					
Comment Code					
Inspector Comment					
FS_ID:34754 DS_ID:19779 EP_NO: N/A Repair Type: No Action Needed Crossing Status: Found UCIP Comments: FIELD_STRUCT_DESC: 24-inch corrugated metal gravity drainage pipe through the levee, 10.3 feet below the crown. Flap gate on the waterside (WS) end. Concrete headwall on the landside (LS) end. Concrete U-shaped headwall on the WS end. [Additional Reference(s): DWR Levee Log, 2002. USACE San Joaquin O&M Manual 601.1, 1967, (HLM 19.84)]. FS Date: 4/23/2014

Headwall and pipe visible on LS toe.

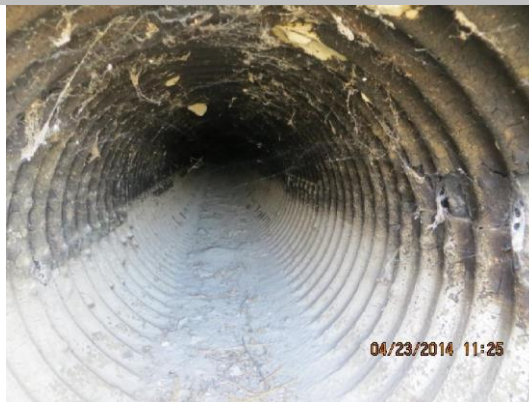
Photo 3 of 3 : UCIP\_SP\_2018\_34754\_62523.jpg

Inside pipe on LS toe.

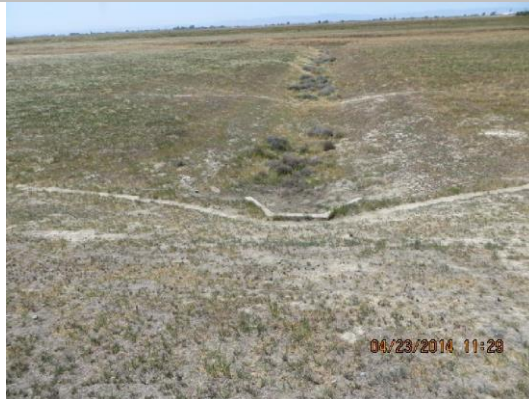
Photo 1 of 3 : UCIP\_SP\_2018\_34755\_62529.jpg

LM Start	19.94	Rating **	A/W	Issue No.	1358	
LM End	19.94	Issue Type +	Ma	Location *		
Category	Supplemental			GPS Latitude/Longitude		
				Start		End
Item	DWR UCIP LMA Responsibility			37.108426 °		37.108426 °
				-120.554990 °		-120.554990 °
DWR ID						
Comment Code						
Inspector Comment						
FS_ID:34755						
DS_ID:19780						
EP_NO: N/A						
Repair Type: No Action Needed						
Crossing Status: Found						
UCIP Comments:						
FIELD_STRUCT_DESC: 36-inch corrugated metal gravity drainage pipe through the levee, 9.8 feet below the crown. Flap gate on the waterside (WS) end. Concrete headwall on the landside (LS) end. Concrete U-shaped headwall on the WS end. [Additional Reference(s): DWR Levee Log, 2002. USACE San Joaquin O&M Manual 601.1, 1967, (HLM 19.92)].						
FS Date: 4/23/2014

Headwall, pipe, and flapgate visible on WS toe.

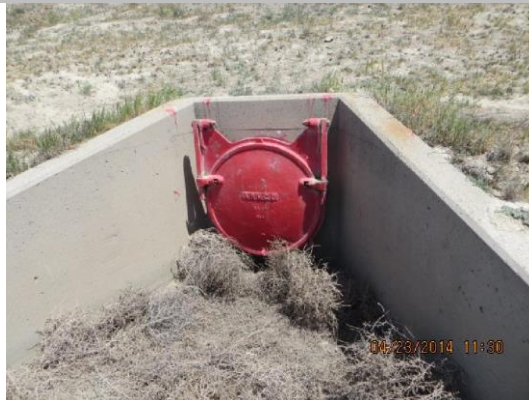
Photo 2 of 3 : UCIP\_SP\_2018\_34755\_62530.jpg

Headwall, pipe, and flapgate visible on WS toe.

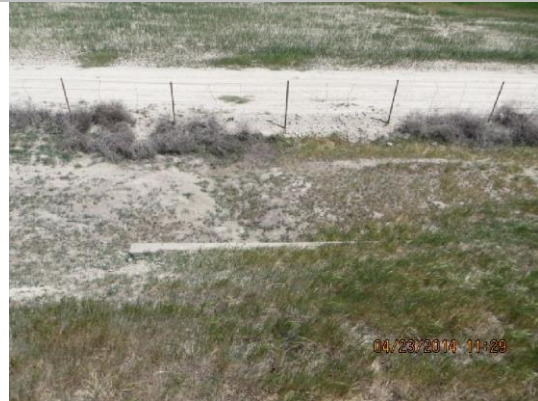
Photo 3 of 3 : UCIP\_SP\_2018\_34755\_62528.jpg

LM Start	19.94	Rating **	A/W	Issue No.	1358 (cont)	
LM End	19.94	Issue Type +	Ma	Location *		
Category	Supplemental			GPS Latitude/Longitude		
				Start	End	
Item	DWR UCIP LMA Responsibility			37.108426 °	37.108426 °	
				-120.554990 °	-120.554990 °	
DWR ID						
Comment Code						
Inspector Comment						
FS_ID:34755 DS_ID:19780 EP_NO: N/A Repair Type: No Action Needed Crossing Status: Found UCIP Comments: FIELD_STRUCT_DESC: 36-inch corrugated metal gravity drainage pipe through the levee, 9.8 feet below the crown. Flap gate on the waterside (WS) end. Concrete headwall on the landside (LS) end. Concrete U-shaped headwall on the WS end. [Additional Reference(s): DWR Levee Log, 2002. USACE San Joaquin O&M Manual 601.1, 1967, (HLM 19.92)]. FS Date: 4/23/2014

Headwall and pipe visible on LS toe.

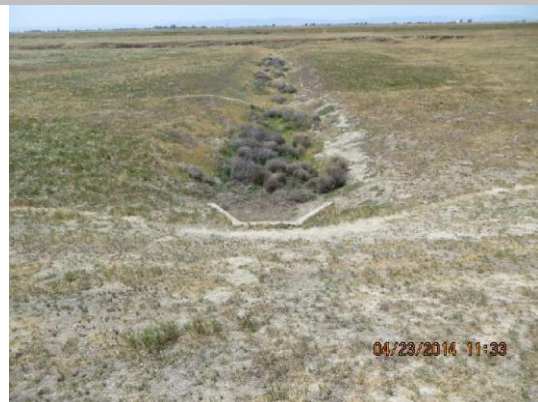
Photo 1 of 3 : UCIP\_SP\_2018\_34757\_62533.jpg

LM Start	20.10	Rating **	A/W	Issue No.	1359
LM End	20.10	Issue Type +	Ma	Location *	
Category	Supplemental			GPS Latitude/Longitude	
				Start	End
Item	DWR UCIP LMA Responsibility			37.107091 °	37.107091 °
				-120.553503 °	-120.553503 °
DWR ID					
Comment Code					
Inspector Comment					
FS_ID:34757 DS_ID:19781 EP_NO: N/A Repair Type: No Action Needed Crossing Status: Found UCIP Comments: FIELD_STRUCT_DESC: 36-inch corrugated metal gravity drainage pipe through the levee, 9.9 feet below the crown. Flap gate on the waterside (WS) end. Concrete headwall on the landside (LS) end. Concrete U-shaped headwall on the WS end. [Additional Reference(s): DWR Levee Log, 2002. USACE San Joaquin O&M Manual 601.1, 1967, (HLM 20.05)]. FS Date: 4/23/2014

Headwall, pipe, and flapgate visible on WS toe.

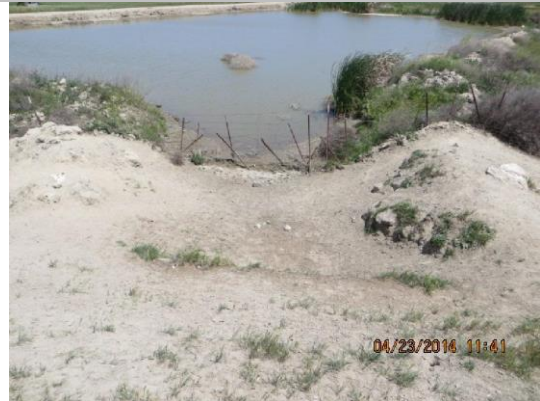
Photo 3 of 3 : UCIP\_SP\_2018\_34760\_62540.jpg

LM Start	20.24	Rating **	A/W	Issue No.	1361 (cont)	
LM End	20.24	Issue Type +	Ma	Location *		
Category	Supplemental			GPS Latitude/Longitude		
				Start	End	
Item	DWR UCIP LMA Responsibility			37.105489 °	37.105489 °	
				-120.551886 °	-120.551886 °	
DWR ID						
Comment Code						
Inspector Comment						
FS_ID:34760						
DS_ID:19783						
EP_NO: N/A						
Repair Type: No Action Needed						
Crossing Status: Found						
UCIP Comments:						
FIELD_STRUCT_DESC: 36-inch corrugated metal gravity drainage pipe						
through the levee, 10.6 feet below the crown. Flap gate on the						
waterside (WS) end. Concrete headwall on each end. [Additional						
Reference(s): DWR Levee Log, 2002. USACE San Joaquin O&M						
Manual 601.1, 1967, (HLM 20.18)].						
FS Date: 4/23/2014

Headwall and pipe visible on LS toe.

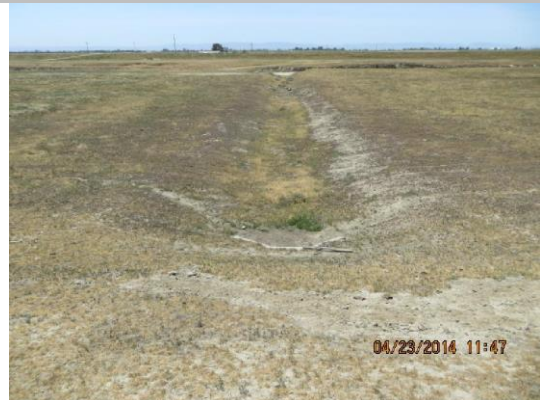
Photo 1 of 3 : UCIP\_SP\_2018\_39605\_62544.jpg

Comment Code					
Inspector Comment					
FS_ID:39605 DS_ID:19784 EP_NO: N/A Repair Type: Non-Urgent Crossing Status: Found UCIP Comments: Dense vegetation limits the inspector's visibility to identify signs of pipe failure (leaks) along the landward slope. Recommend removing vegetation along pipe alignment to conduct proper inspection of structure. FIELD_STRUCT_DESC: 24-inch corrugated metal gravity drainage pipe through the levee, 10.5 feet below the crown. Flap gate on the waterside (WS) end. Concrete headwall on the landside (LS) end. Concrete U-shaped headwall on the WS end. [Additional Reference(s): DWR Levee Log, 2002. USACE San Joaquin O&M Manual 601.1, 1967, (HLM 20.59)]. FS Date: 4/23/2014

Headwall, pipe, and flapgate visible on WS toe.

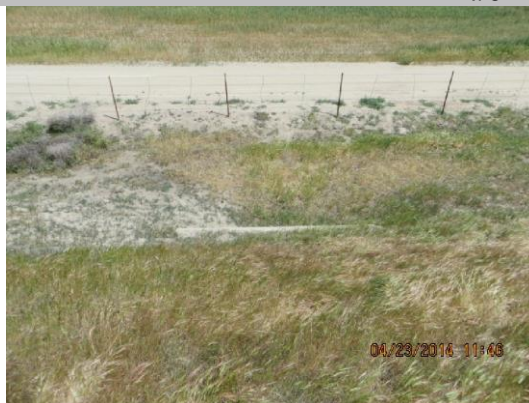
Photo 3 of 3 : UCIP\_SP\_2018\_39605\_62545.jpg

FS\_ID:39605  
DS\_ID:19784  
EP\_NO: N/A  
Repair Type: Non-Urgent  
Crossing Status: Found  
UCIP Comments: Dense vegetation limits the inspector's visibility to identify signs of pipe failure (leaks) along the landward slope. Recommend removing vegetation along pipe alignment to conduct proper inspection of structure.  
FIELD\_STRUCT\_DESC: 24-inch corrugated metal gravity drainage pipe through the levee, 10.5 feet below the crown. Flap gate on the waterside (WS) end. Concrete headwall on the landside (LS) end. Concrete U-shaped headwall on the WS end. [Additional Reference(s): DWR Levee Log, 2002. USACE San Joaquin O&M Manual 601.1, 1967, (HLM 20.59)].  
FS Date: 4/23/2014

Headwall and pipe visible on LS toe.

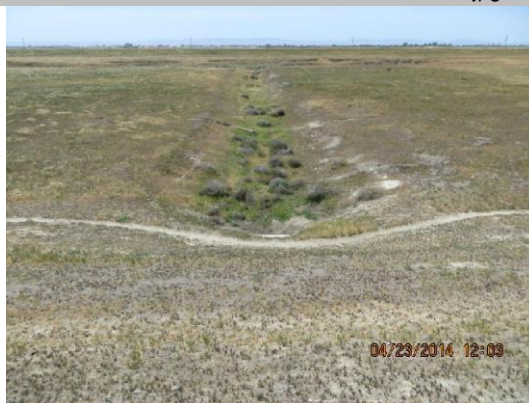
Photo 1 of 3 : UCIP\_SP\_2018\_39606\_62549.jpg

Comment Code					
Inspector Comment					
FS_ID:39606 DS_ID:19785 EP_NO: N/A Repair Type: Non-Urgent Crossing Status: Found UCIP Comments: Dense vegetation limits the inspector's visibility to identify signs of pipe failure (leaks) along the landward slope. Recommend removing vegetation along pipe alignment to conduct proper inspection of structure. FIELD_STRUCT_DESC: 24-inch corrugated metal gravity drainage pipe through the levee, 11.8 feet below the crown. Flap gate on the waterside (WS) end. Concrete headwall on the landside (LS) end. Concrete U-shaped headwall on the WS end. [Additional Reference(s): DWR Levee Log, 2002. USACE San Joaquin O&M Manual 601.1, 1967, (HLM 21.08)]. FS Date: 4/23/2014

Headwall, pipe, and flapgate visible on WS toe.

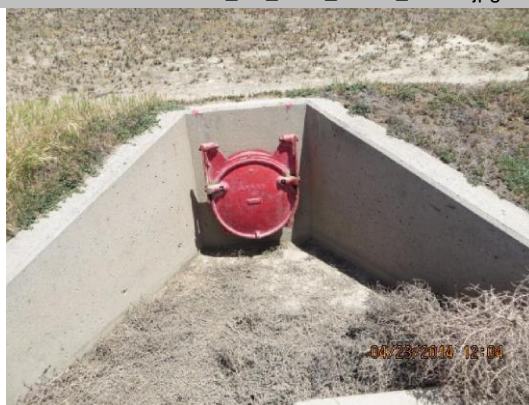
Photo 2 of 3 : UCIP\_SP\_2018\_39606\_62551.jpg

Headwall, pipe, and flapgate visible on WS toe.

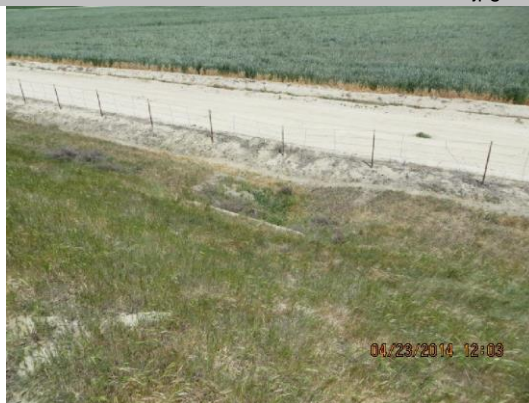
Photo 3 of 3 : UCIP\_SP\_2018\_39606\_62550.jpg

Item	DWR UCIP LMA Responsibility			37.095603 °	37.095603 °	
				-120.541593 °	-120.541593 °	
DWR ID						
Comment Code						
Inspector Comment						
FS_ID:39606 DS_ID:19785 EP_NO: N/A Repair Type: Non-Urgent Crossing Status: Found UCIP Comments: Dense vegetation limits the inspector's visibility to identify signs of pipe failure (leaks) along the landward slope. Recommend removing vegetation along pipe alignment to conduct proper inspection of structure. FIELD_STRUCT_DESC: 24-inch corrugated metal gravity drainage pipe through the levee, 11.8 feet below the crown. Flap gate on the waterside (WS) end. Concrete headwall on the landside (LS) end. Concrete U-shaped headwall on the WS end. [Additional Reference(s): DWR Levee Log, 2002. USACE San Joaquin O&M Manual 601.1, 1967, (HLM 21.08)]. FS Date: 4/23/2014

Headwall and pipe visible on LS toe.

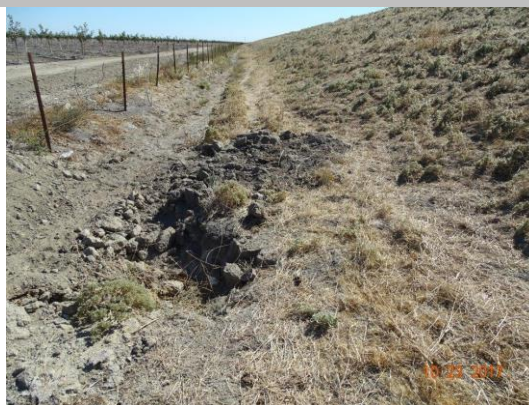
Photo 1 of 1 : SP\_2018\_NA0010\_123\_120\_20180307\_00025.jpg

LM Start	21.45	Rating **	M	Issue No.	120
LM End	21.45	Issue Type +	Ma	Location *	LS
Category	Earthen Levee			GPS Latitude/Longitude	
				Start	End
Item	Erosion / Bank Caving			37.092064 °	37.092064 °
				-120.537750 °	-120.537750 °
DWR ID	DWR_NA0010_05_f_2017_120				
Comment Code					
E2 : Schedule repair of erosion site prior to the next inspection.					
Inspector Comment					
Repair holes dug at the landside toe.

Looking southeast at the landside toe.

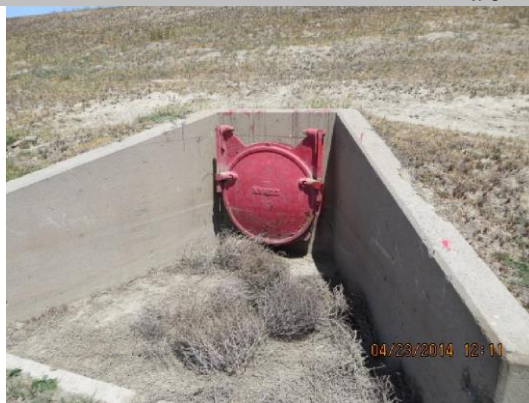
Photo 2 of 3 : UCIP\_SP\_2018\_39614\_62556.jpg

Comment Code					
Inspector Comment					
FS_ID:39614 DS_ID:19786 EP_NO: N/A Repair Type: Non-Urgent Crossing Status: Found UCIP Comments: Dense vegetation limits the inspector's visibility to identify signs of pipe failure (leaks) along the landward slope. Recommend removing vegetation along pipe alignment to conduct proper inspection of structure. FIELD_STRUCT_DESC: 36-inch corrugated metal gravity drainage pipe through the levee, 12.7 feet below the crown. Flap gate on the waterside (WS) end. Concrete headwall on the landside (LS) end. Concrete U-shaped headwall on the WS end. [Additional Reference(s): DWR Levee Log, 2002. USACE San Joaquin O&M Manual 601.1, 1967, (HLM 21.42)]. FS Date: 4/23/2014

Headwall, pipe, and flapgate visible on WS toe.

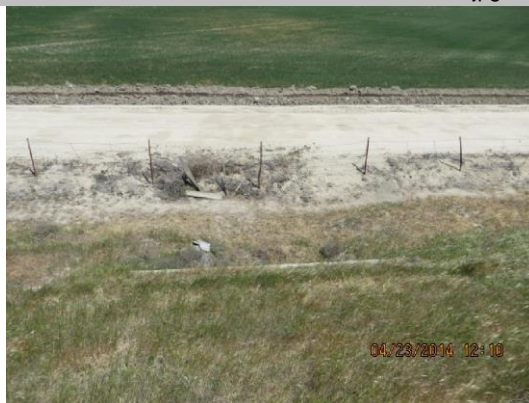
Photo 3 of 3 : UCIP\_SP\_2018\_39614\_62554.jpg

Comment Code					
Inspector Comment					
FS_ID:39614 DS_ID:19786 EP_NO: N/A Repair Type: Non-Urgent Crossing Status: Found UCIP Comments: Dense vegetation limits the inspector's visibility to identify signs of pipe failure (leaks) along the landward slope. Recommend removing vegetation along pipe alignment to conduct proper inspection of structure. FIELD_STRUCT_DESC: 36-inch corrugated metal gravity drainage pipe through the levee, 12.7 feet below the crown. Flap gate on the waterside (WS) end. Concrete headwall on the landside (LS) end. Concrete U-shaped headwall on the WS end. [Additional Reference(s): DWR Levee Log, 2002. USACE San Joaquin O&M Manual 601.1, 1967, (HLM 21.42)]. FS Date: 4/23/2014

Headwall and pipe visible on LS toe.

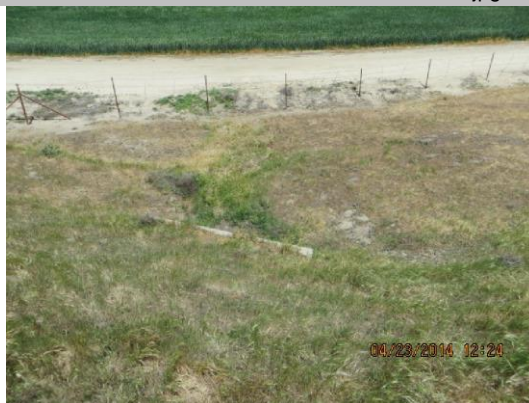
Photo 3 of 3 : UCIP\_SP\_2018\_39883\_62560.jpg

Item	DWR UCIP LMA Responsibility			37.087525 °		37.087525 °
				-120.532827 °		-120.532827 °
DWR ID						
Comment Code						
Inspector Comment						
FS_ID:39883 DS_ID:19787 EP_NO: N/A Repair Type: Non-Urgent Crossing Status: Found UCIP Comments: Dense vegetation limits the inspector's visibility to identify signs of pipe failure (leaks) along the landward slope. Recommend removing vegetation along pipe alignment to conduct proper inspection of structure. FIELD_STRUCT_DESC: 24-inch corrugated metal gravity drainage pipe through the levee, 12.4 feet below the crown. Flap gate on the waterside (WS) end. Concrete headwall on the landside (LS) end. Concrete U-shaped headwall on the WS end. [Additional Reference(s): DWR Levee Log, 2002. USACE San Joaquin O&M Manual 601.1, 1967, (HLM 21.81)]. FS Date: 4/23/2014

Headwall and pipe visible on LS toe.

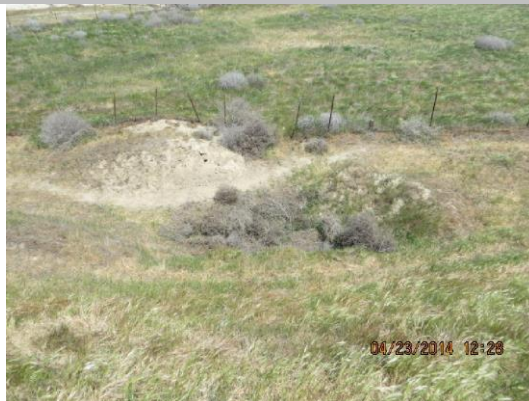
Photo 3 of 3 : UCIP\_SP\_2018\_39610\_62587.jpg

Item	DWR UCIP LMA Responsibility			37.087108 °	37.087108 °	
				-120.532374 °	-120.532374 °	
DWR ID						
Comment Code						
Inspector Comment						
FS_ID:39610						
DS_ID:19788						
EP_NO: N/A						
Repair Type: Non-Urgent						
Crossing Status: Found						
UCIP Comments: Dense vegetation limits the inspector's visibility to identify signs of pipe failure (leaks) along the landward slope.						
Recommend removing vegetation along pipe alignment to conduct proper inspection of structure.						
FIELD_STRUCT_DESC: 24-inch corrugated metal gravity drainage pipe through the levee, 10.7 feet below the crown. Flap gate on the waterside (WS) end. Concrete headwall on the landside (LS) end. Concrete U-shaped headwall on the WS end. [Additional Reference(s): DWR Levee Log, 2002. USACE San Joaquin O&M Manual 601.1, 1967, (HLM 21.85)].						
FS Date: 4/23/2014

Headwall and pipe visible on LS toe.

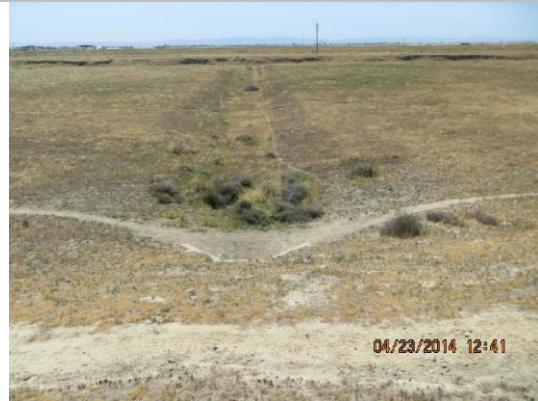
Photo 1 of 3 : UCIP\_SP\_2018\_39611\_62591.jpg

FS\_ID:39611  
DS\_ID:19789  
EP\_NO: N/A  
Repair Type: Non-Urgent  
Crossing Status: Found  
UCIP Comments: Dense vegetation limits the inspector's visibility to identify signs of pipe failure (leaks) along the landward slope. Recommend removing vegetation along pipe alignment to conduct proper inspection of structure. Sediment buildup in pipe visible from landward side--recommend contacting owner to clear pipe.  
FIELD\_STRUCT\_DESC: 24-inch corrugated metal gravity drainage pipe through the levee, 10.2 feet below the crown. Flap gate on the waterside (WS) end. Concrete headwall on the landside (LS) end. Concrete U-shaped headwall on the WS end. [Additional Reference(s): DWR Levee Log, 2002. USACE San Joaquin O&M Manual 601.1, 1967, (HLM 22.19)].  
FS Date: 4/23/2014

Headwall, pipe, and flapgate visible on WS toe.

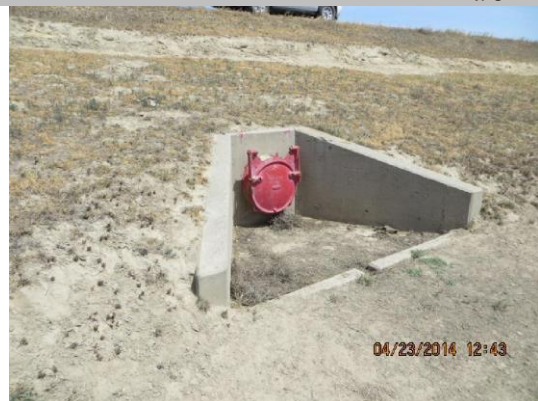
Photo 2 of 3 : UCIP\_SP\_2018\_39611\_62593.jpg

Headwall, pipe, and flapgate visible on WS toe.

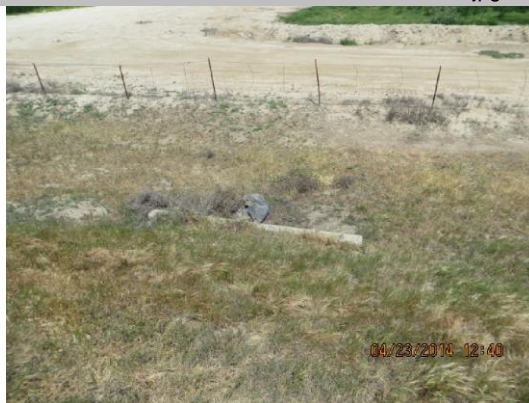
Photo 3 of 3 : UCIP\_SP\_2018\_39611\_62592.jpg

Item	DWR UCIP LMA Responsibility			37.083410 °	37.083410 °	
				-120.528356 °	-120.528356 °	
DWR ID						
Comment Code						
Inspector Comment						
FS_ID:39611 DS_ID:19789 EP_NO: N/A Repair Type: Non-Urgent Crossing Status: Found UCIP Comments: Dense vegetation limits the inspector's visibility to identify signs of pipe failure (leaks) along the landward slope. Recommend removing vegetation along pipe alignment to conduct proper inspection of structure. Sediment buildup in pipe visible from landward side--recommend contacting owner to clear pipe. FIELD_STRUCT_DESC: 24-inch corrugated metal gravity drainage pipe through the levee, 10.2 feet below the crown. Flap gate on the waterside (WS) end. Concrete headwall on the landside (LS) end. Concrete U-shaped headwall on the WS end. [Additional Reference(s): DWR Levee Log, 2002. USACE San Joaquin O&M Manual 601.1, 1967, (HLM 22.19)]. FS Date: 4/23/2014

Headwall and pipe visible on LS toe.

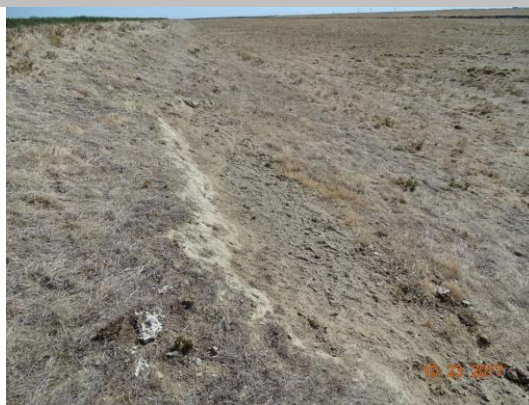
Photo 1 of 1 : SP\_2018\_NA0010\_123\_121\_20180307\_00026.jpg

LM Start	22.35	Rating **	M	Issue No.	121
LM End	22.35	Issue Type +	Ma	Location *	WS
Category	Earthen Levee			GPS Latitude/Longitude	
				Start	End
Item	Erosion / Bank Caving			37.082696 °	37.082696 °
				-120.527620 °	-120.527620 °
DWR ID	DWR_NA0010_05_f_2017_121				
Comment Code					
E1 : Note and monitor erosion site.					
Inspector Comment					
Waterside slope damaged by animal traffic.

Looking southeast at the waterside slope.

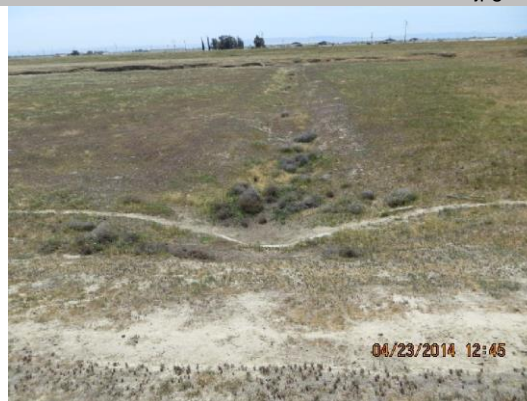
Photo 1 of 3 : UCIP\_SP\_2018\_39613\_62596.jpg

FS\_ID:39613  
DS\_ID:19790  
EP\_NO: N/A  
Repair Type: Non-Urgent  
Crossing Status: Found  
UCIP Comments: Dense vegetation limits the inspector's visibility to identify signs of pipe failure (leaks) along the landward slope. Recommend removing vegetation along pipe alignment to conduct proper inspection of structure. Sediment buildup in pipe visible from landward side--recommend contacting owner to clear pipe.  
FIELD\_STRUCT\_DESC: 24-inch corrugated metal gravity drainage pipe through the levee, 10.4 feet below the crown. Flap gate on the waterside (WS) end. Concrete headwall on the landside (LS) end. Concrete U-shaped headwall on the WS end. [Additional Reference(s): DWR Levee Log, 2002. USACE San Joaquin O&M Manual 601.1, 1967, (HLM 22.79)].  
FS Date: 4/23/2014

Headwall, pipe, and flapgate visible on WS toe.

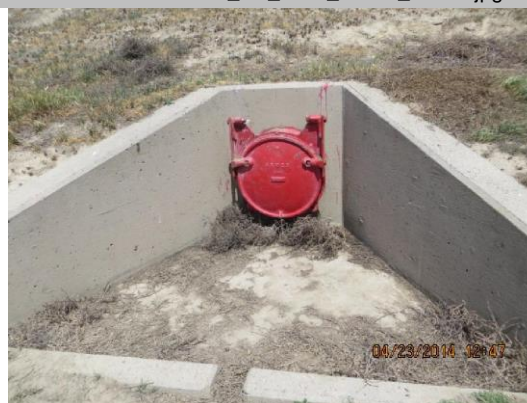
Photo 2 of 3 : UCIP\_SP\_2018\_39613\_62598.jpg

Headwall, pipe, and flapgate visible on WS toe.

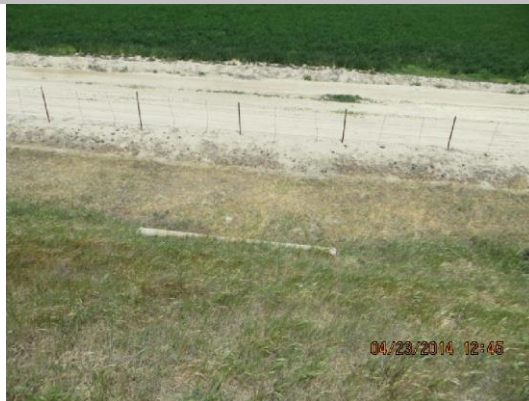
Photo 3 of 3 : UCIP\_SP\_2018\_39613\_62597.jpg

Headwall and pipe visible on LS toe.

Comment Code					
Inspector Comment					
FS_ID:39613 DS_ID:19790 EP_NO: N/A Repair Type: Non-Urgent Crossing Status: Found UCIP Comments: Dense vegetation limits the inspector's visibility to identify signs of pipe failure (leaks) along the landward slope. Recommend removing vegetation along pipe alignment to conduct proper inspection of structure. Sediment buildup in pipe visible from landward side--recommend contacting owner to clear pipe. FIELD_STRUCT_DESC: 24-inch corrugated metal gravity drainage pipe through the levee, 10.4 feet below the crown. Flap gate on the waterside (WS) end. Concrete headwall on the landside (LS) end. Concrete U-shaped headwall on the WS end. [Additional Reference(s): DWR Levee Log, 2002. USACE San Joaquin O&M Manual 601.1, 1967, (HLM 22.79)]. FS Date: 4/23/2014

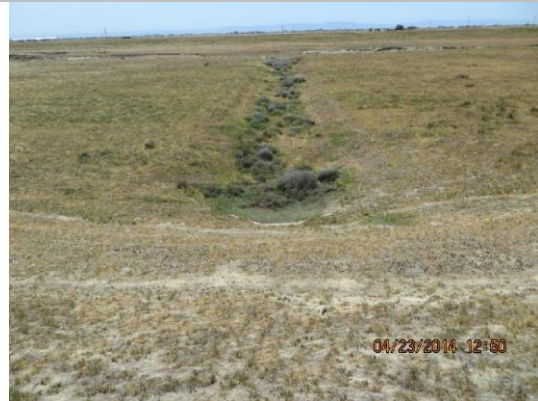
Photo 1 of 3 : UCIP\_SP\_2018\_39616\_62601.jpg

FS\_ID:39616  
DS\_ID:19791  
EP\_NO: N/A  
Repair Type: Non-Urgent  
Crossing Status: Found  
UCIP Comments: Dense vegetation limits the inspector's visibility to identify signs of pipe failure (leaks) along the landward slope. Recommend removing vegetation along pipe alignment to conduct proper inspection of structure. Sediment buildup in pipe visible from landward side--recommend contacting owner to clear pipe.  
FIELD\_STRUCT\_DESC: 24-inch corrugated metal gravity drainage pipe through the levee, 12.2 feet below the crown. Flap gate on the waterside (WS) end. Concrete headwall on the landside (LS) end. Concrete U-shaped headwall on the WS end. [Additional Reference(s): DWR Levee Log, 2002. USACE San Joaquin O&M Manual 601.1, 1967, (HLM 22.94)].  
FS Date: 4/23/2014

Headwall, pipe, and flapgate visible on WS toe.

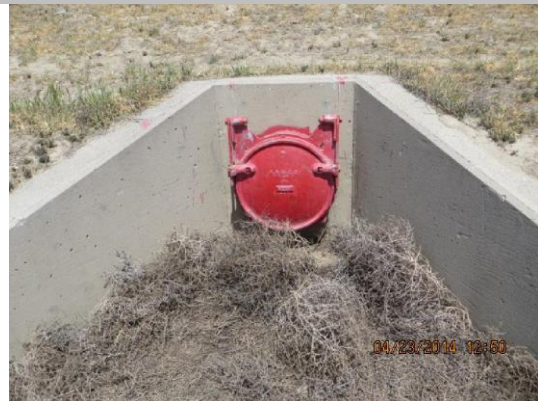
Photo 2 of 3 : UCIP\_SP\_2018\_39616\_62600.jpg

Headwall, pipe, and flapgate visible on WS toe.

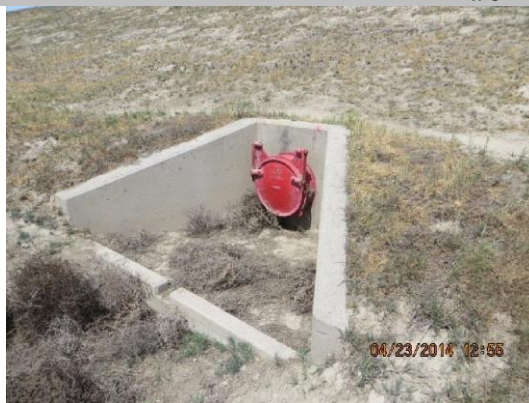
Photo 2 of 3 : UCIP\_SP\_2018\_39617\_62608.jpg

Headwall, pipe, and flapgate visible on WS toe.

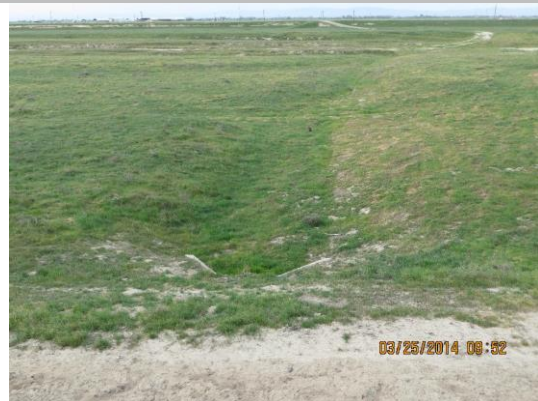
Photo 1 of 3 : UCIP\_SP\_2018\_32763\_59262.jpg

LM Start	23.25	Rating **	A/W	Issue No.	1372
LM End	23.25	Issue Type +	Ma	Location *	
Category	Supplemental			GPS Latitude/Longitude	
				Start	End
Item	DWR UCIP LMA Responsibility			37.072989 °	37.072989 °
				-120.516687 °	-120.516687 °
DWR ID					
Comment Code					
Inspector Comment					
FS_ID:32763 DS_ID:19794 EP_NO: N/A Repair Type: No Action Needed Crossing Status: Found UCIP Comments: FIELD_STRUCT_DESC: 30-inch corrugated metal gravity drainage pipe through the levee, 11.6 feet below the crown. Flap gate on the waterside (WS) end. Concrete headwall on the landside (LS) end. Concrete U-shaped headwall on the WS end. [Additional Reference(s): DWR Levee Log, 2002. USACE San Joaquin O&M Manual 601.1, 1967, (HLM 23.15)]. FS Date: 3/25/2014 9:04:45 AM

Concrete headwall on WS toe.

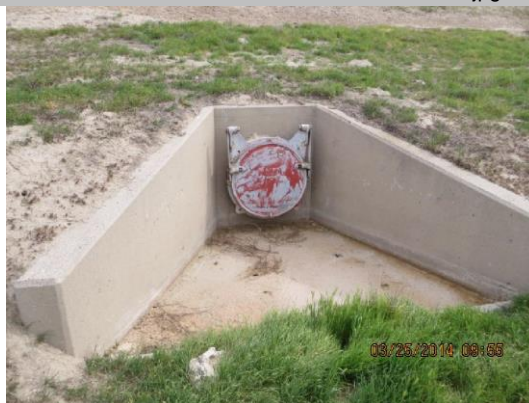
Photo 2 of 3 : UCIP\_SP\_2018\_32763\_59263.jpg

Flapgate and concrete headwall on WS toe.

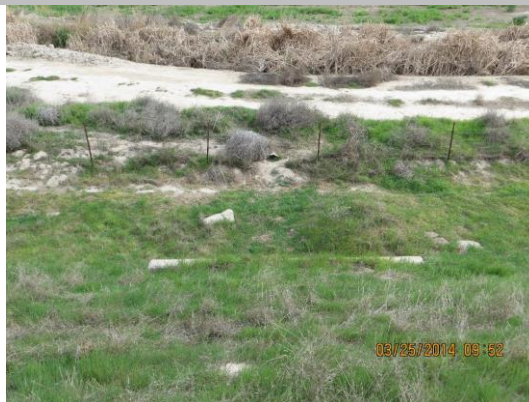
Photo 3 of 3 : UCIP\_SP\_2018\_32763\_59261.jpg

Concrete headwall on LS toe.

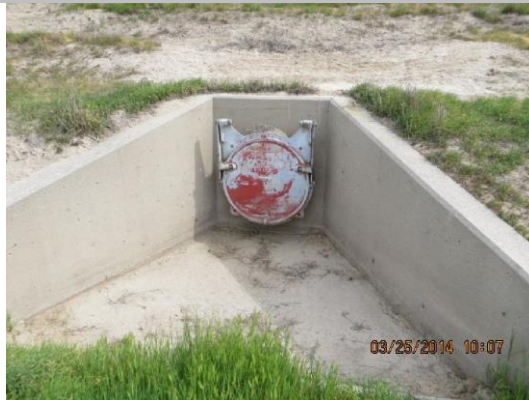
Photo 2 of 3 : UCIP\_SP\_2018\_39621\_59270.jpg

Flapgate on Concrete headwall on WS toe.

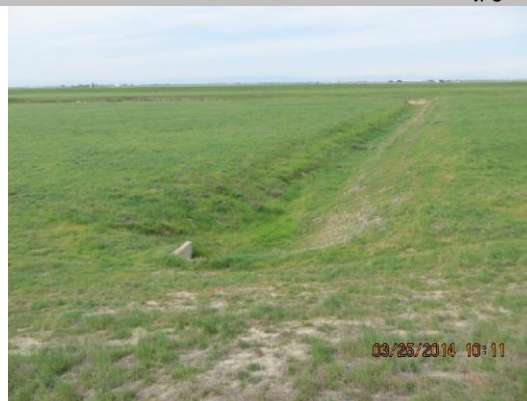
Photo 1 of 3 : UCIP\_SP\_2018\_39620\_59282.jpg

LM Start	24.02	Rating **	M	Issue No.	1374
LM End	24.02	Issue Type +	Ma	Location *	
Category	Supplemental			GPS Latitude/Longitude	
				Start	End
Item	DWR UCIP LMA Responsibility			37.064494 °	37.064494 °
				-120.507531 °	-120.507531 °
DWR ID					
Comment Code					
Inspector Comment					
FS_ID:39620 DS_ID:19797 EP_NO: N/A Repair Type: Non-Urgent Crossing Status: Found UCIP Comments: Minor sediment/debris buildup in pipe visible from landward side--recommend contacting owner to clear pipe. FIELD_STRUCT_DESC: 36-inch corrugated metal gravity drainage pipe through the levee, 12.1 feet below the crown. Flap gate on the waterside (WS) end. Concrete headwall on the landside (LS) end. Concrete U-shaped headwall on the WS end. [Additional Reference(s): DWR Levee Log, 2002. USACE San Joaquin O&M Manual 601.1, 1967, (HLM 23.85)]. FS Date: 3/25/2014

Concrete headwall on WS toe.

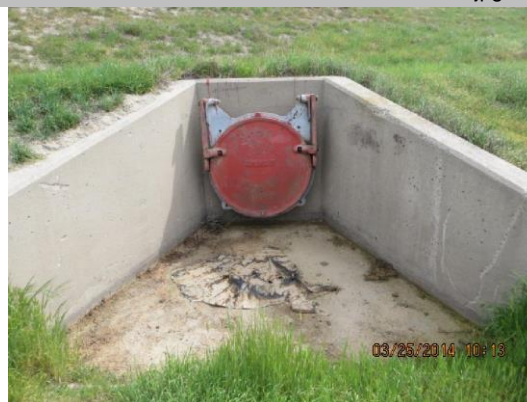
Photo 2 of 3 : UCIP\_SP\_2018\_39620\_59280.jpg

Flapgate at Concrete headwall on WS toe.

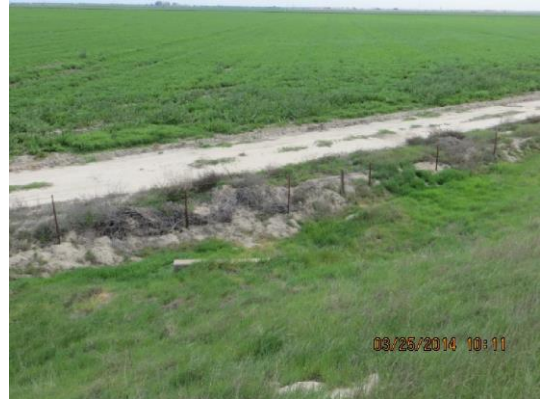
Photo 3 of 3 : UCIP\_SP\_2018\_39620\_59281.jpg

Concrete headwall on LS toe.
