**Flood Control Project Maintenance  
Levee Inspections**

## Maintenance Issue Types Only, Levee Inspection Report By Mile - Spring 2018

### Lower San Joaquin Levee District

Waterway	Bank	Unit Miles	Inspection Start/End	Inspector
Unit No. 01 San Joaquin River	Right	22.52	04/04/2018 04/16/2018	Richard Willoughby

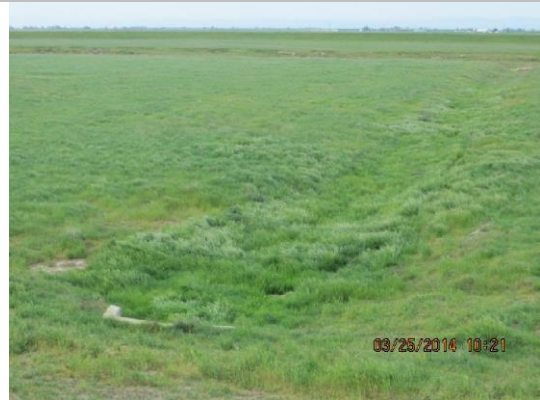
Photo 1 of 3 : UCIP\_SP\_2018\_46850\_59287.jpg

Comment Code					
Inspector Comment					
FS_ID:46850 DS_ID:19798 EP_NO: N/A Repair Type: Non-Urgent Crossing Status: Found UCIP Comments: Dense vegetation limits the inspector's visibility to identify signs of pipe failure (leaks) along the landward slope. Recommend removing vegetation along pipe alignment to conduct proper inspection of structure. FIELD_STRUCT_DESC: 24-inch corrugated metal gravity drainage pipe through the levee, 11.2 feet below the crown. Flap gate on the waterside (WS) end. Concrete headwall on the landside (LS) end. Concrete U-shaped headwall on the WS end. [Additional Reference(s): DWR Levee Log, 2002. USACE San Joaquin O&M Manual 601.1, 1967, (HLM 24.18)]. FS Date: 3/25/2014

Concrete headwall at WS toe.

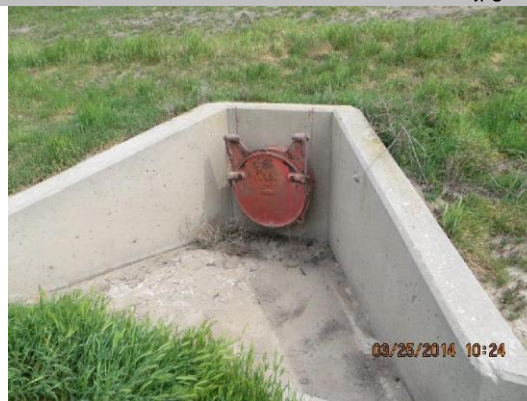
Photo 2 of 3 : UCIP\_SP\_2018\_46850\_59285.jpg

Flapgate at concrete headwall at WS toe.

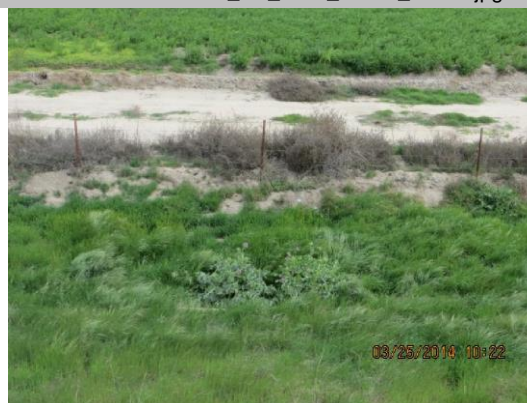
Photo 3 of 3 : UCIP\_SP\_2018\_46850\_59286.jpg

Concrete headwall at LS toe.

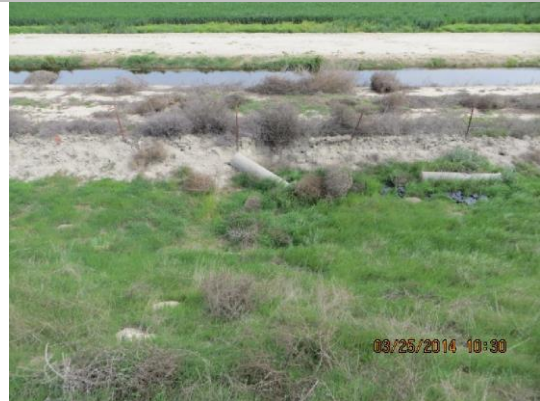
Photo 3 of 3 : UCIP\_SP\_2018\_39623\_59291.jpg

Item	DWR UCIP LMA Responsibility			37.058673 °	37.058673 °	
				-120.501238 °	-120.501238 °	
DWR ID						
Comment Code						
Inspector Comment						
FS_ID:39623 DS_ID:19799 EP_NO: N/A Repair Type: Non-Urgent Crossing Status: Found UCIP Comments: Dense vegetation limits the inspector's visibility to identify signs of pipe failure (leaks) along the landward slope. Recommend removing vegetation along pipe alignment to conduct proper inspection of structure. FIELD_STRUCT_DESC: 24-inch corrugated metal gravity drainage pipe through the levee, 11.2 feet below the crown. Flap gate on the waterside (WS) end. Concrete headwall on the landside (LS) end. Concrete U-shaped headwall on the WS end. [Additional Reference(s): DWR Levee Log, 2002. USACE San Joaquin O&M Manual 601.1, 1967, (HLM 24.46)]. FS Date: 3/25/2014

Concrete headwall on LS toe.

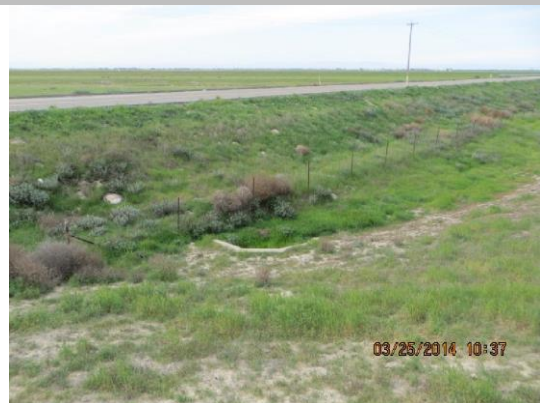
Photo 1 of 3 : UCIP\_SP\_2018\_32786\_59297.jpg

LM Start	24.93	Rating **	A/W	Issue No.	1377
LM End	24.93	Issue Type +	Ma	Location *	
Category	Supplemental			GPS Latitude/Longitude	
				Start	End
Item	DWR UCIP LMA Responsibility			37.054481 °	37.054481 °
				-120.496798 °	-120.496798 °
DWR ID					
Comment Code					
Inspector Comment					
FS_ID:32786 DS_ID:19800 EP_NO: N/A Repair Type: No Action Needed Crossing Status: Found UCIP Comments: FIELD_STRUCT_DESC: 24-inch corrugated metal gravity drainage pipe through the levee, 10.7 feet below the crown. Flap gate on the waterside (WS) end. Concrete headwall on the landside (LS) end. Concrete U-shaped headwall on the WS end. [Additional Reference(s): DWR Levee Log, 2002. USACE San Joaquin O&M Manual 601.1, 1967, (HLM 24.82)]. FS Date: 3/25/2014

Concrete headwall on WS toe.

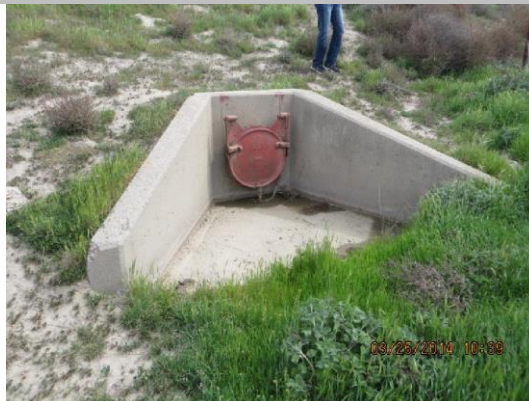
Photo 2 of 3 : UCIP\_SP\_2018\_32786\_59295.jpg

Flapgate on concrete headwall on WS toe.

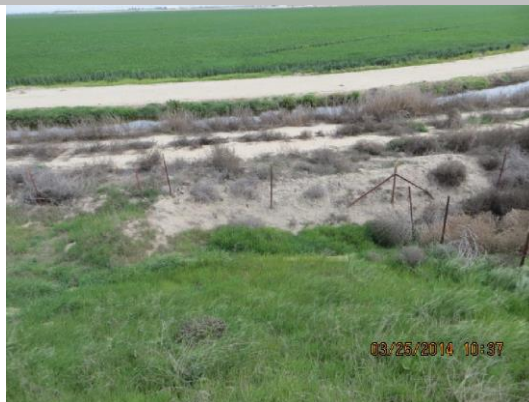
Photo 3 of 3 : UCIP\_SP\_2018\_32786\_59296.jpg

Concrete headwall on LS toe.

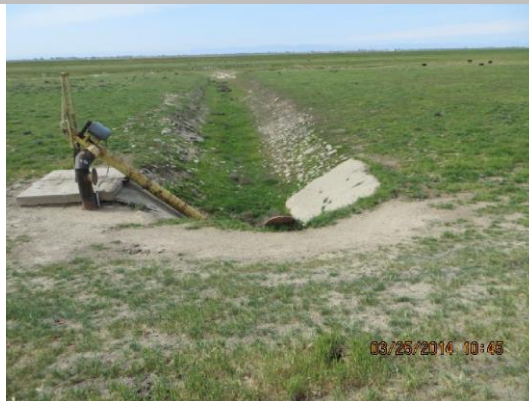
Photo 1 of 3 : UCIP\_SP\_2018\_39624\_59302.jpg

LM Start	24.96	Rating **	A/W	Issue No.	1378
LM End	24.96	Issue Type +	Ma	Location *	
Category	Supplemental			GPS Latitude/Longitude	
				Start	End
Item	DWR UCIP LMA Responsibility			37.054344 °	37.054344 °
				-120.496214 °	-120.496214 °
DWR ID					
Comment Code					
Inspector Comment					
FS_ID:39624 DS_ID:19801 EP_NO: N/A Repair Type: No Action Needed Crossing Status: Found UCIP Comments: FIELD_STRUCT_DESC: 30-inch corrugated metal gravity drainage pipe through the levee, 10.9 feet below the crown. Flap gate on the waterside (WS) end. Concrete headwall on the landside (LS) end. Concrete U-shaped headwall on the WS end. [Additional Reference(s): DWR Levee Log, 2002. USACE San Joaquin O&M Manual 601.1, 1967, (HLM 24.87)]. FS Date: 3/25/2014

Flapgate and channel off WS toe.

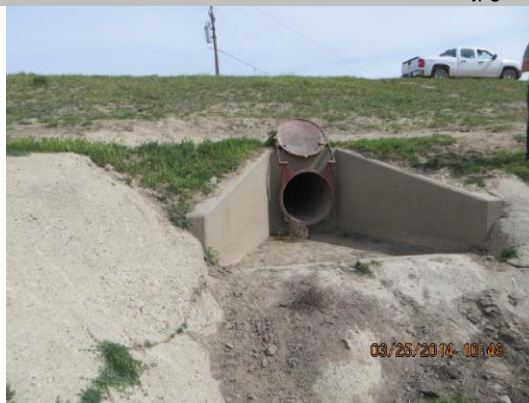
Photo 3 of 3 : UCIP\_SP\_2018\_39624\_59303.jpg

Flapgate on headwall at WS toe.

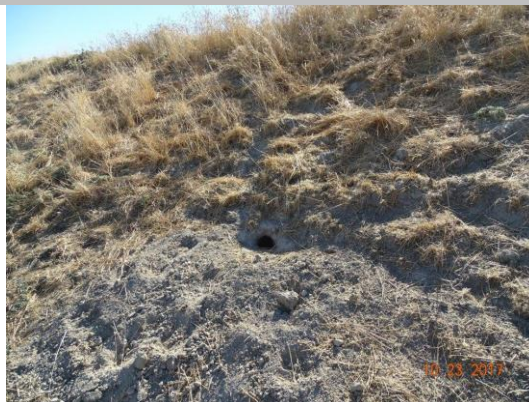
Photo 1 of 1 : SP\_2018\_NA0010\_123\_123\_20180307\_00028.jpg

LM Start	24.98	Rating **	M	Issue No.	123
LM End	25.26	Issue Type +	Ma	Location *	LS
Category	Earthen Levee			GPS Latitude/Longitude	
				Start	End
Item	Animal Control			37.054150 °	37.051252 °
				-120.495964 °	-120.492368 °
DWR ID	DWR_NA0010_05_f_2017_123				
Comment Code					
A3 : No rodents visible, but rodent burrows visible; need to backfill and compact or grout burrows.					
Inspector Comment

Looking southwest at the landside slope.

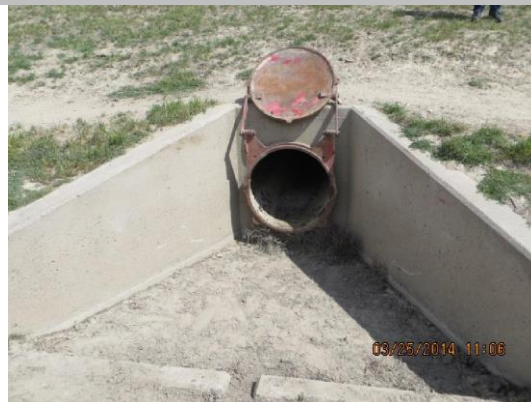
Photo 2 of 3 : UCIP\_SP\_2018\_32789\_59312.jpg

LM Start	25.24	Rating **	M	Issue No.	1380
LM End	25.24	Issue Type +	Ma	Location *	
Category	Supplemental			GPS Latitude/Longitude	
				Start	End
Item	DWR UCIP LMA Responsibility			37.051477 °	37.051477 °
				-120.492650 °	-120.492650 °
DWR ID					
Comment Code					
Inspector Comment					
FS_ID:32789 DS_ID:19803 EP_NO: N/A Repair Type: Non-Urgent Crossing Status: Found UCIP Comments: Flapgate propped open during flood season. FIELD_STRUCT_DESC: 30-inch corrugated metal gravity drainage pipe through the levee, 11.3 feet below the crown. Flap gate on the waterside (WS) end. Concrete headwall on the landside (LS) end. Concrete U-shaped headwall on the WS end. [Additional Reference(s): DWR Levee Log, 2002. USACE San Joaquin O&M Manual 601.1, 1967, (HLM 25.13)]. FS Date: 3/25/2014

Concrete headwall and flapgate on WS toe.

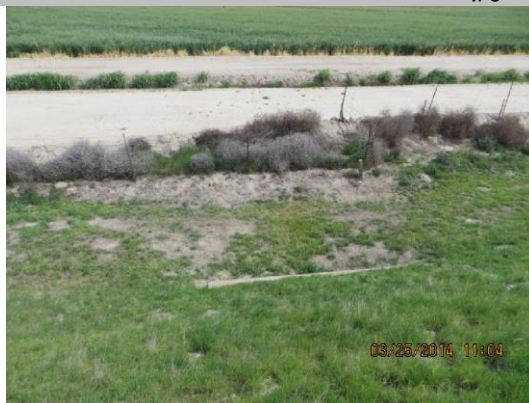
Photo 3 of 3 : UCIP\_SP\_2018\_32789\_59310.jpg

LM Start	25.24	Rating **	M	Issue No.	1380 (cont)	
LM End	25.24	Issue Type +	Ma	Location *		
Category	Supplemental			GPS Latitude/Longitude		
				Start		End
Item	DWR UCIP LMA Responsibility			37.051477 °		37.051477 °
				-120.492650 °		-120.492650 °
DWR ID						
Comment Code						
Inspector Comment						
FS_ID:32789						
DS_ID:19803						
EP_NO: N/A						
Repair Type: Non-Urgent						
Crossing Status: Found						
UCIP Comments: Flapgate propped open during flood season.						
FIELD_STRUCT_DESC: 30-inch corrugated metal gravity drainage pipe						
through the levee, 11.3 feet below the crown. Flap gate on the						
waterside (WS) end. Concrete headwall on the landside (LS) end.						
Concrete U-shaped headwall on the WS end. [Additional Reference(s):						
DWR Levee Log, 2002. USACE San Joaquin O&M Manual 601.1, 1967,						
(HLM 25.13)].						
FS Date: 3/25/2014

Concrete headwall on LS toe.

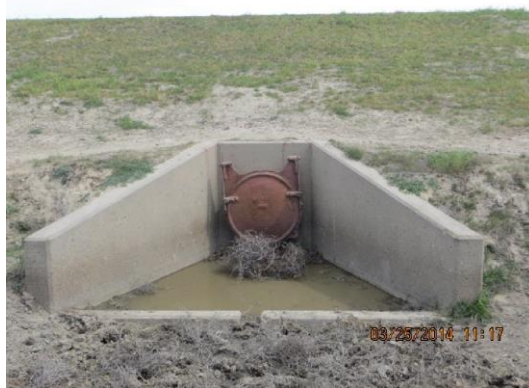
Photo 2 of 3 : UCIP\_SP\_2018\_39625\_59317.jpg

Flapgate on concrete headwall at WS toe.

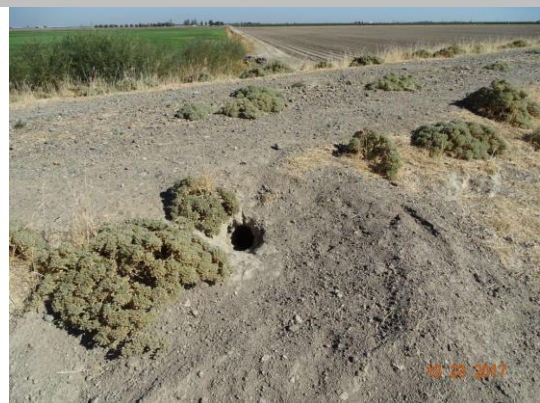
Photo 1 of 1 : SP\_2018\_NA0010\_123\_124\_20180307\_00029.jpg

LM Start	25.61	Rating **	U	Issue No.	124
LM End	25.61	Issue Type +	Ma	Location *	WS
Category	Earthen Levee			GPS Latitude/Longitude	
				Start	End
Item	Animal Control			37.047416 °	37.047416 °
				-120.488411 °	-120.488411 °
DWR ID	DWR_NA0010_05_f_2017_124				
Comment Code					
A3 : No rodents visible, but rodent burrows visible; need to backfill and compact or grout burrows.					
Inspector Comment

Looking east at the waterside slope.

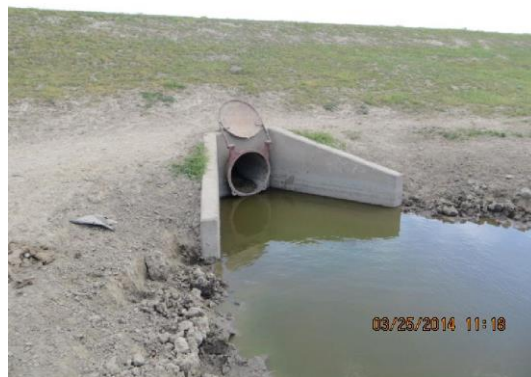
Photo 1 of 3 : UCIP\_SP\_2018\_39626\_59321.jpg

LM Start	25.63	Rating **	M	Issue No.	1382
LM End	25.63	Issue Type +	Ma	Location *	
Category	Supplemental			GPS Latitude/Longitude	
				Start	End
Item	DWR UCIP LMA Responsibility			37.047170 °	37.047170 °
				-120.488222 °	-120.488222 °
DWR ID					
Comment Code					
Inspector Comment					
FS_ID:39626 DS_ID:19805 EP_NO: N/A Repair Type: Non-Urgent Crossing Status: Found UCIP Comments: Sediment buildup in pipe visible from landward side--recommend contacting owner to clear pipe. FIELD_STRUCT_DESC: 30-inch corrugated metal gravity drainage pipe through the levee, 12.1 feet below the crown. Flap gate on the waterside (WS) end. Concrete headwall on the landside (LS) end. Concrete U-shaped headwall on the WS end. [Additional Reference(s): DWR Levee Log, 2002. USACE San Joaquin O&M Manual 601.1, 1967, (HLM 25.53)]. FS Date: 3/25/2014

Flapgate on headwall at WS toe.

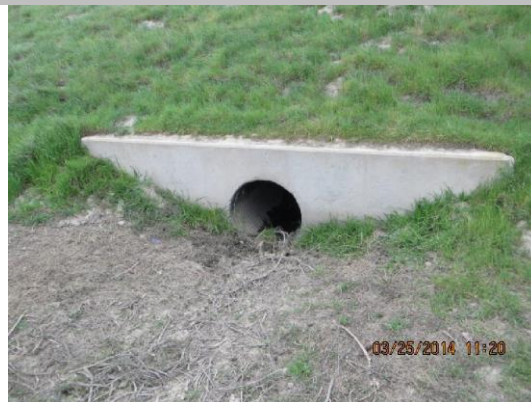
Photo 2 of 3 : UCIP\_SP\_2018\_39626\_59320.jpg

Concrete headwall on LS toe.

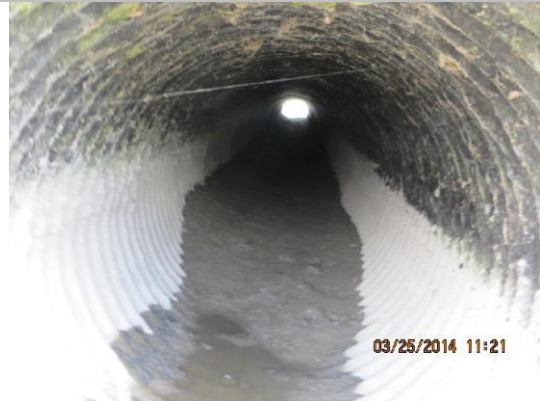
Photo 3 of 3 : UCIP\_SP\_2018\_39626\_59319.jpg

LM Start	25.63	Rating **	M	Issue No.	1382 (cont)
LM End	25.63	Issue Type +	Ma	Location *	
Category	Supplemental			GPS Latitude/Longitude	
				Start	End
Item	DWR UCIP LMA Responsibility			37.047170 °	37.047170 °
				-120.488222 °	-120.488222 °
DWR ID					
Comment Code					
Inspector Comment					
FS_ID:39626 DS_ID:19805 EP_NO: N/A Repair Type: Non-Urgent Crossing Status: Found UCIP Comments: Sediment buildup in pipe visible from landward side-- recommend contacting owner to clear pipe. FIELD_STRUCT_DESC: 30-inch corrugated metal gravity drainage pipe through the levee, 12.1 feet below the crown. Flap gate on the waterside (WS) end. Concrete headwall on the landside (LS) end. Concrete U-shaped headwall on the WS end. [Additional Reference(s): DWR Levee Log, 2002. USACE San Joaquin O&M Manual 601.1, 1967, (HLM 25.53)]. FS Date: 3/25/2014

Inside pipe on LS toe.

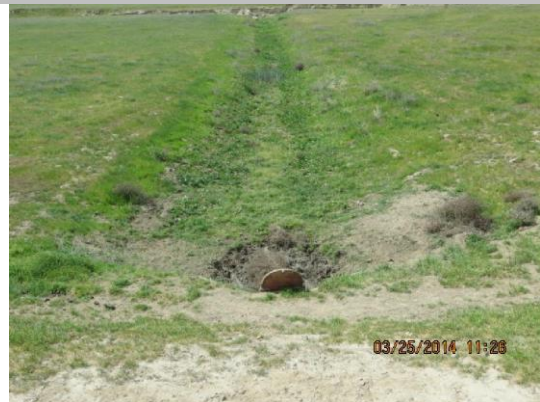
Photo 1 of 3 : UCIP\_SP\_2018\_39627\_59341.jpg

LM Start	26.20	Rating **	M	Issue No.	1383
LM End	26.20	Issue Type +	Ma	Location *	
Category	Supplemental			GPS Latitude/Longitude	
				Start	End
Item	DWR UCIP LMA Responsibility			37.040070 °	37.040070 °
				-120.482796 °	-120.482796 °
DWR ID					
Comment Code					
Inspector Comment					
FS_ID:39627 DS_ID:19806 EP_NO: N/A Repair Type: Non-Urgent Crossing Status: Found UCIP Comments: Sediment buildup in pipe visible from landward side-- recommend contacting owner to clear pipe. FIELD_STRUCT_DESC: 24-inch corrugated metal gravity drainage pipe through the levee, 10 feet below the crown. Flap gate on the waterside (WS) end. Concrete headwall on the landside (LS) end. Concrete U-shaped headwall on the WS end. [Additional Reference(s): DWR Levee Log, 2002. USACE San Joaquin O&M Manual 601.1, 1967, (HLM 26.11)]. FS Date: 3/25/2014

Concrete headwall on WS toe.

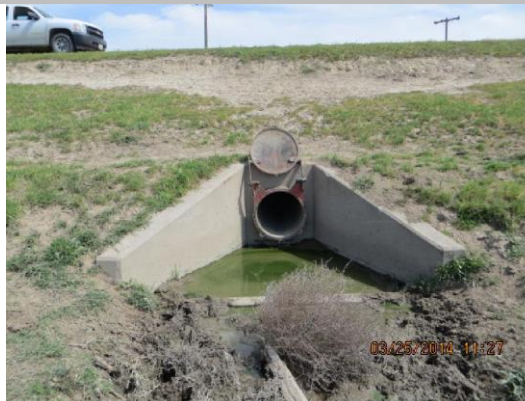
Photo 2 of 3 : UCIP\_SP\_2018\_39627\_59340.jpg

LM Start	26.20	Rating **	M	Issue No.	1383 (cont)	
LM End	26.20	Issue Type +	Ma	Location *		
Category	Supplemental			GPS Latitude/Longitude		
				Start	End	
Item	DWR UCIP LMA Responsibility			37.040070 °	37.040070 °	
				-120.482796 °	-120.482796 °	
DWR ID						
Comment Code						
Inspector Comment						
FS_ID:39627 DS_ID:19806 EP_NO: N/A Repair Type: Non-Urgent Crossing Status: Found UCIP Comments: Sediment buildup in pipe visible from landward side--recommend contacting owner to clear pipe. FIELD_STRUCT_DESC: 24-inch corrugated metal gravity drainage pipe through the levee, 10 feet below the crown. Flap gate on the waterside (WS) end. Concrete headwall on the landside (LS) end. Concrete U-shaped headwall on the WS end. [Additional Reference(s): DWR Levee Log, 2002. USACE San Joaquin O&M Manual 601.1, 1967, (HLM 26.11)]. FS Date: 3/25/2014

Flapgate on Concrete headwall at WS toe.

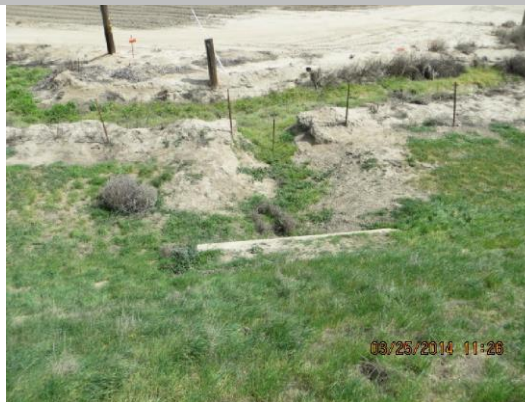
Photo 3 of 3 : UCIP\_SP\_2018\_39627\_59342.jpg

Concrete headwall on LS toe.

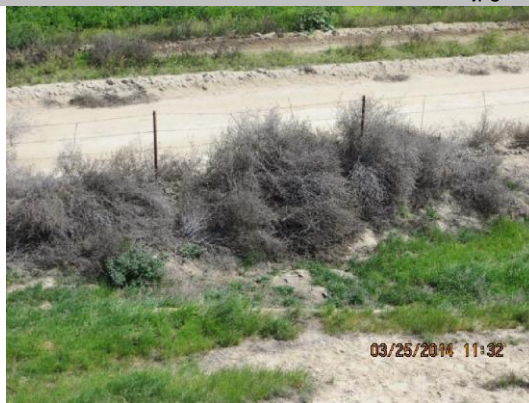
Photo 1 of 3 : UCIP\_SP\_2018\_32804\_59347.jpg

LM Start	26.39	Rating **	A/W	Issue No.	1384
LM End	26.39	Issue Type +	Ma	Location *	
Category	Supplemental			GPS Latitude/Longitude	
				Start	End
Item	DWR UCIP LMA Responsibility			37.037772 °	37.037772 °
				-120.481028 °	-120.481028 °
DWR ID					
Comment Code					
Inspector Comment					
FS_ID:32804 DS_ID:19807 EP_NO: N/A Repair Type: No Action Needed Crossing Status: Found UCIP Comments: FIELD_STRUCT_DESC: 36-inch corrugated metal gravity drainage pipe through the levee, 13 feet below the crown. Flap gate on the waterside (WS) end. Concrete headwall on the landside (LS) end. Concrete U-shaped headwall on the WS end. [Additional Reference(s): DWR Levee Log, 2002. USACE San Joaquin O&M Manual 601.1, 1967, (HLM 26.29)]. FS Date: 3/25/2014

Concrete headwall on LS toe.

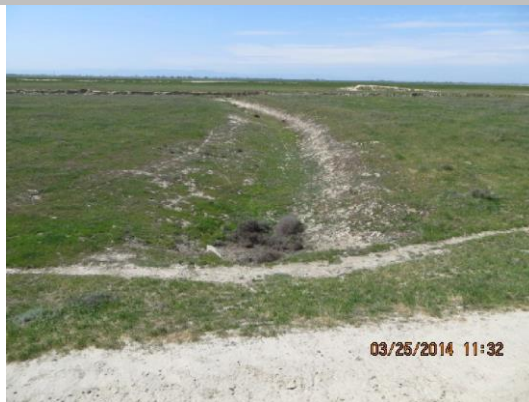
Photo 2 of 3 : UCIP\_SP\_2018\_32804\_59346.jpg

Concrete headwall on WS toe.

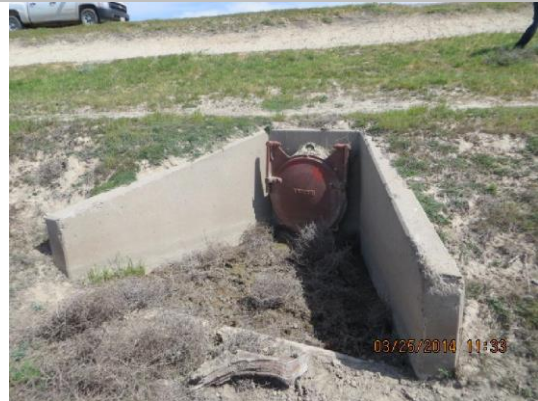
Photo 3 of 3 : UCIP\_SP\_2018\_32804\_59345.jpg

LM Start	26.39	Rating **	A/W	Issue No.	1384 (cont)
LM End	26.39	Issue Type +	Ma	Location *	
Category	Supplemental			GPS Latitude/Longitude	
				Start	End
Item	DWR UCIP LMA Responsibility			37.037772 °	37.037772 °
				-120.481028 °	-120.481028 °
DWR ID					
Comment Code					
Inspector Comment					
FS_ID:32804					
DS_ID:19807					
EP_NO: N/A					
Repair Type: No Action Needed					
Crossing Status: Found					
UCIP Comments:					
FIELD_STRUCT_DESC: 36-inch corrugated metal gravity drainage pipe through the levee, 13 feet below the crown. Flap gate on the waterside (WS) end. Concrete headwall on the landside (LS) end. Concrete U-shaped headwall on the WS end. [Additional Reference(s): DWR Levee Log, 2002. USACE San Joaquin O&M Manual 601.1, 1967, (HLM 26.29)].					
FS Date: 3/25/2014

Flapgate on Concrete headwall at WS toe.

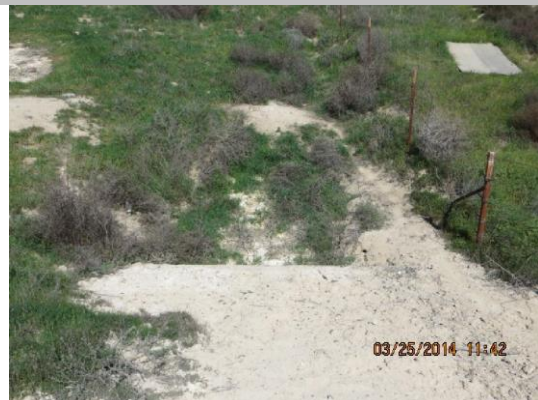
Photo 1 of 3 : UCIP\_SP\_2018\_39628\_59350.jpg

LM Start	26.95	Rating **	M	Issue No.	1385
LM End	26.95	Issue Type +	Ma	Location *	
Category	Supplemental			GPS Latitude/Longitude	
				Start	End
Item	DWR UCIP LMA Responsibility			37.032669 °	37.032669 °
				-120.473901 °	-120.473901 °
DWR ID					
Comment Code					
Inspector Comment					
FS_ID:39628 DS_ID:19808 EP_NO: N/A Repair Type: Non-Urgent Crossing Status: Found UCIP Comments: Pipe has heavy silt buildup visible from landward side--recommend contacting owner to clear pipe. FIELD_STRUCT_DESC: 24-inch corrugated metal gravity drainage pipe through the levee, 11.4 feet below the crown. Flap gate on the waterside (WS) end. Concrete headwall on the landside (LS) end. Concrete U-shaped headwall on the WS end. [Additional Reference(s): DWR Levee Log, 2002. USACE San Joaquin O&M Manual 601.1, 1967, (HLM 26.85)]. FS Date: 3/25/2014

Concrete headwall on LS toe.

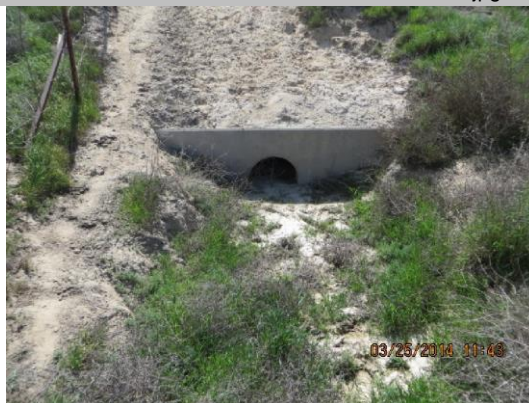
Photo 2 of 3 : UCIP\_SP\_2018\_39628\_59349.jpg

LM Start	26.95	Rating **	M	Issue No.	1385 (cont)	
LM End	26.95	Issue Type +	Ma	Location *		
Category	Supplemental			GPS Latitude/Longitude		
				Start	End	
Item	DWR UCIP LMA Responsibility			37.032669 °	37.032669 °	
				-120.473901 °	-120.473901 °	
DWR ID						
Comment Code						
Inspector Comment						
FS_ID:39628 DS_ID:19808 EP_NO: N/A Repair Type: Non-Urgent Crossing Status: Found UCIP Comments: Pipe has heavy silt buildup visible from landward side--recommend contacting owner to clear pipe. FIELD_STRUCT_DESC: 24-inch corrugated metal gravity drainage pipe through the levee, 11.4 feet below the crown. Flap gate on the waterside (WS) end. Concrete headwall on the landside (LS) end. Concrete U-shaped headwall on the WS end. [Additional Reference(s): DWR Levee Log, 2002. USACE San Joaquin O&M Manual 601.1, 1967, (HLM 26.85)]. FS Date: 3/25/2014

Concrete headwall on LS toe.

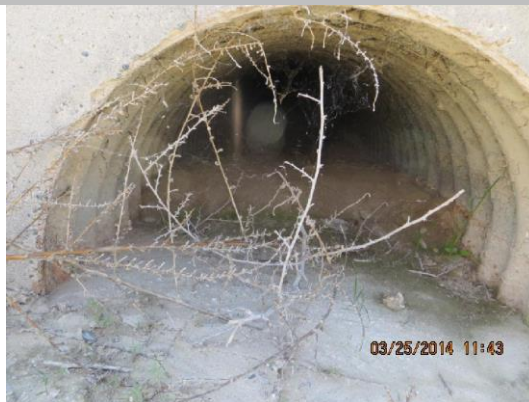
Photo 3 of 3 : UCIP\_SP\_2018\_39628\_59348.jpg

Silt buildup in pipe at LS toe.

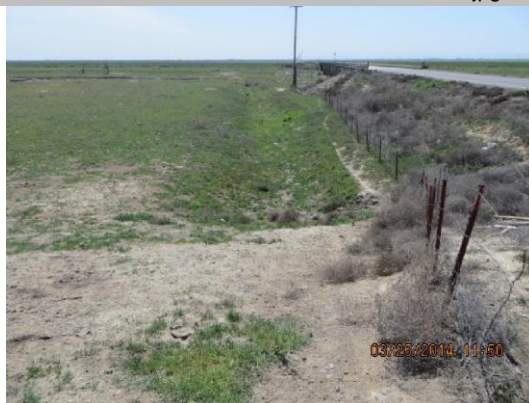
Photo 1 of 3 : UCIP\_SP\_2018\_32806\_59353.jpg

LM Start	26.97	Rating **	M	Issue No.	1386
LM End	26.97	Issue Type +	Ma	Location *	
Category	Supplemental			GPS Latitude/Longitude	
				Start	End
Item	DWR UCIP LMA Responsibility			37.032680 °	37.032680 °
				-120.473454 °	-120.473454 °
DWR ID					
Comment Code					
Inspector Comment					
FS_ID:32806 DS_ID:19748 EP_NO: N/A Repair Type: Non-Urgent Crossing Status: Found UCIP Comments: Tumble weed buildup at inlet mat create blockage and should be removed. FIELD_STRUCT_DESC: 24-inch corrugated metal gravity drainage pipe through the levee, 11.3 feet below the crown. Flap gate on the waterside (WS) end. Concrete headwall on the landside (LS) end. Concrete U-shaped headwall on the WS end. [Additional Reference(s): DWR Levee Log, 2002. USACE San Joaquin O&M Manual 601.1, 1967, (HLM 26.87)]. FS Date: 3/25/2014

Concrete headwall at WS toe.

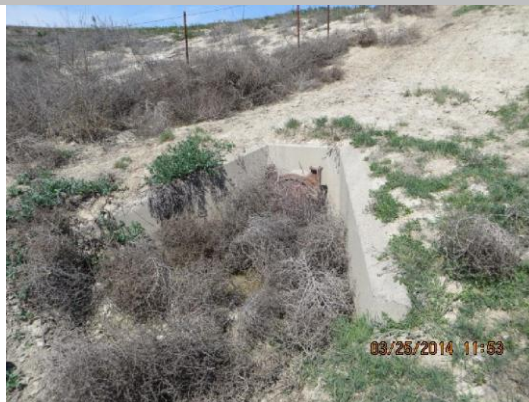
Photo 2 of 3 : UCIP\_SP\_2018\_32806\_59355.jpg

Flapgate and Concrete headwall at WS toe.

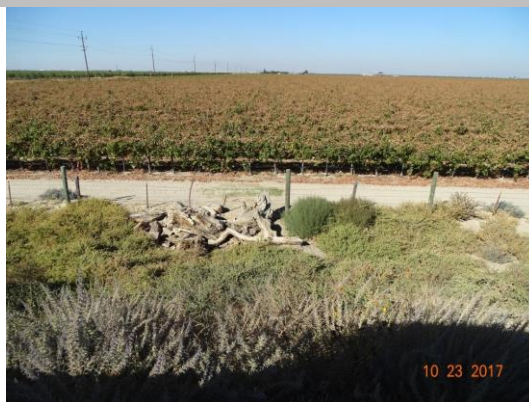
Photo 1 of 1 : SP\_2018\_NA0010\_123\_125\_20180307\_00030.jpg

LM Start	27.01	Rating **	M	Issue No.	125
LM End	27.01	Issue Type +	Ma	Location *	LS
Category	Earthen Levee			GPS Latitude/Longitude	
				Start	End
Item	Encroachments			37.032675 °	37.032675 °
				-120.472841 °	-120.472841 °
DWR ID	DWR_NA0010_05_f_2017_125				
Comment Code					
TR : Tree or limb					
Inspector Comment

Looking north at the landside slope.

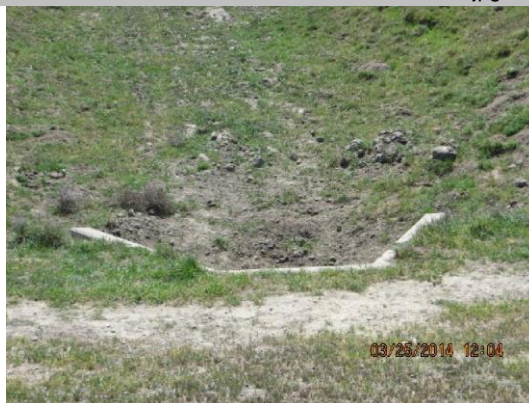
Photo 1 of 3 : UCIP\_SP\_2018\_32807\_59358.jpg

LM Start	27.31	Rating **	A/W	Issue No.	1387
LM End	27.31	Issue Type +	Ma	Location *	
Category	Supplemental			GPS Latitude/Longitude	
				Start	End
Item	DWR UCIP LMA Responsibility			37.032668 °	37.032668 °
				-120.467299 °	-120.467299 °
DWR ID					
Comment Code					
Inspector Comment					
FS_ID:32807 DS_ID:19749 EP_NO: N/A Repair Type: No Action Needed Crossing Status: Found UCIP Comments: FIELD_STRUCT_DESC: 36-inch corrugated metal gravity drainage pipe through the levee, 12 feet below the crown. Flap gate on the waterside (WS) end. Concrete headwall on the landside (LS) end. Concrete U-shaped headwall on the WS end. [Additional Reference(s): DWR Levee Log, 2002. USACE San Joaquin O&M Manual 601.1, 1967, (HLM 27.22)]. FS Date: 3/25/2014

Concrete headwall on WS toe.

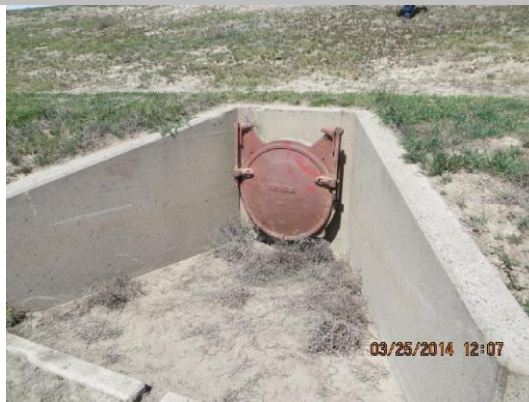
Photo 2 of 3 : UCIP\_SP\_2018\_32807\_59359.jpg

Flapgate at Concrete headwall on WS toe.

LM Start	27.31	Rating **	A/W	Issue No.	1387 (cont)	
LM End	27.31	Issue Type +	Ma	Location *		
Category	Supplemental			GPS Latitude/Longitude		
				Start	End	
Item	DWR UCIP LMA Responsibility			37.032668 °	37.032668 °	
				-120.467299 °	-120.467299 °	
DWR ID						
Comment Code						
Inspector Comment						
FS_ID:32807						
DS_ID:19749						
EP_NO: N/A						
Repair Type: No Action Needed						
Crossing Status: Found						
UCIP Comments:						
FIELD_STRUCT_DESC: 36-inch corrugated metal gravity drainage pipe through the levee, 12 feet below the crown. Flap gate on the waterside (WS) end. Concrete headwall on the landside (LS) end. Concrete U-shaped headwall on the WS end. [Additional Reference(s): DWR Levee Log, 2002. USACE San Joaquin O&M Manual 601.1, 1967, (HLM 27.22)].						
FS Date: 3/25/2014

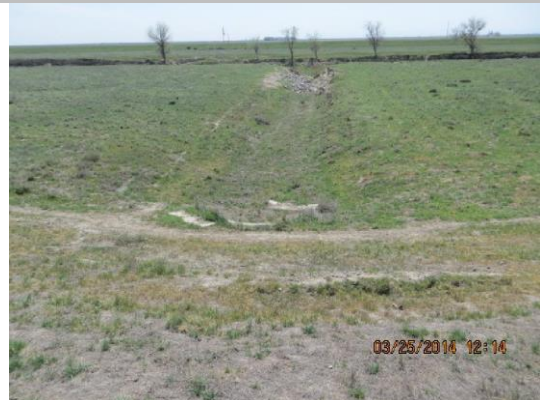
Photo 1 of 3 : UCIP\_SP\_2018\_32823\_59382.jpg

LM Start	28.27	Rating **	M	Issue No.	1388
LM End	28.27	Issue Type +	Ma	Location *	
Category	Supplemental			GPS Latitude/Longitude	
				Start	End
Item	DWR UCIP LMA Responsibility			37.032623 °	37.032623 °
				-120.450108 °	-120.450108 °
DWR ID					
Comment Code					
Inspector Comment					
FS_ID:32823 DS_ID:19750 EP_NO: N/A Repair Type: Non-Urgent Crossing Status: Found UCIP Comments: Animal Burrowing activity at LS toe may undermine headwall. FIELD_STRUCT_DESC: 24-inch corrugated metal gravity drainage pipe through the levee, 10.8 feet below the crown. Flap gate on the waterside (WS) end. Concrete headwall on the landside (LS) end. Concrete U-shaped headwall on the WS end. [Additional Reference(s): DWR Levee Log, 2002. USACE San Joaquin O&M Manual 601.1, 1967, (HLM 28.17)]. FS Date: 3/25/2014

Concrete headwall on WS toe.

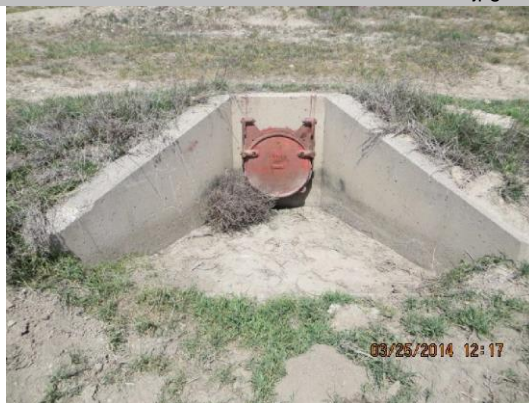
Photo 2 of 3 : UCIP\_SP\_2018\_32823\_59383.jpg

LM Start	28.27	Rating **	M	Issue No.	1388 (cont)	
LM End	28.27	Issue Type +	Ma	Location *		
Category	Supplemental			GPS Latitude/Longitude		
				Start	End	
Item	DWR UCIP LMA Responsibility			37.032623 °	37.032623 °	
				-120.450108 °	-120.450108 °	
DWR ID						
Comment Code						
Inspector Comment						
FS_ID:32823 DS_ID:19750 EP_NO: N/A Repair Type: Non-Urgent Crossing Status: Found UCIP Comments: Animal Burrowing activity at LS toe may undermine headwall. FIELD_STRUCT_DESC: 24-inch corrugated metal gravity drainage pipe through the levee, 10.8 feet below the crown. Flap gate on the waterside (WS) end. Concrete headwall on the landside (LS) end. Concrete U-shaped headwall on the WS end. [Additional Reference(s): DWR Levee Log, 2002. USACE San Joaquin O&M Manual 601.1, 1967, (HLM 28.17)]. FS Date: 3/25/2014

Flapgate on Concrete headwall at WS toe.

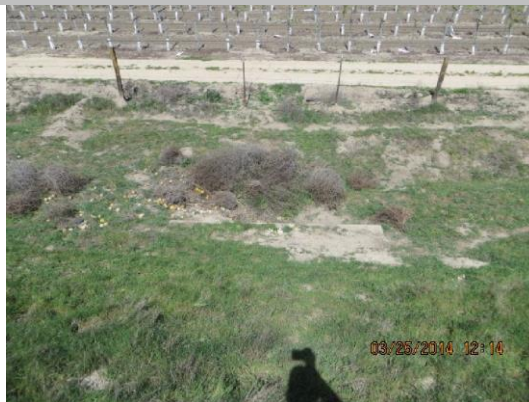
Photo 3 of 3 : UCIP\_SP\_2018\_32823\_59381.jpg

Concrete headwall on LS toe.

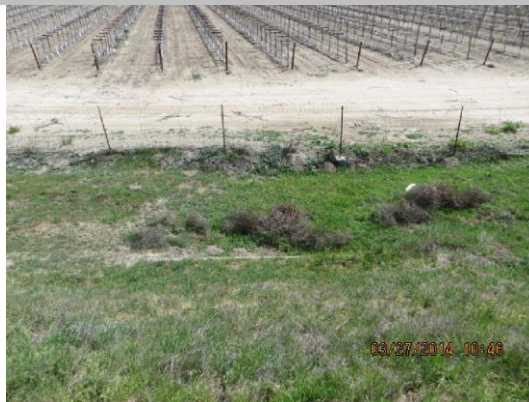
Photo 2 of 3 : UCIP\_SP\_2018\_32832\_59419.jpg

Concrete headwall on LS toe.

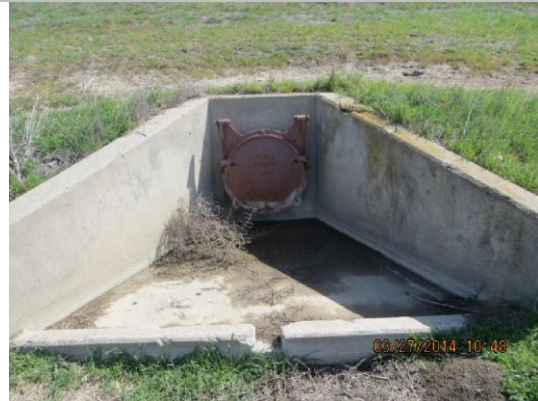
Photo 3 of 3 : UCIP\_SP\_2018\_32832\_59418.jpg

LM Start	28.79	Rating **	A/W	Issue No.	1389 (cont)	
LM End	28.79	Issue Type +	Ma	Location *		
Category	Supplemental			GPS Latitude/Longitude		
				Start	End	
Item	DWR UCIP LMA Responsibility			37.031640 °	37.031640 °	
				-120.441389 °	-120.441389 °	
DWR ID						
Comment Code						
Inspector Comment						
FS_ID:32832						
DS_ID:19751						
EP_NO: N/A						
Repair Type: No Action Needed						
Crossing Status: Found						
UCIP Comments:						
FIELD_STRUCT_DESC: 30-inch corrugated metal gravity drainage pipe through the levee, 9.8 feet below the crown. Flap gate on the waterside (WS) end. Concrete headwall on the landside (LS) end. Concrete U-shaped headwall on the WS end. [Additional Reference(s): DWR Levee Log, 2002. USACE San Joaquin O&M Manual 601.1, 1967, (HLM 28.69)].						
FS Date: 3/27/2014

Flapgate on Concrete headwall at WS toe.

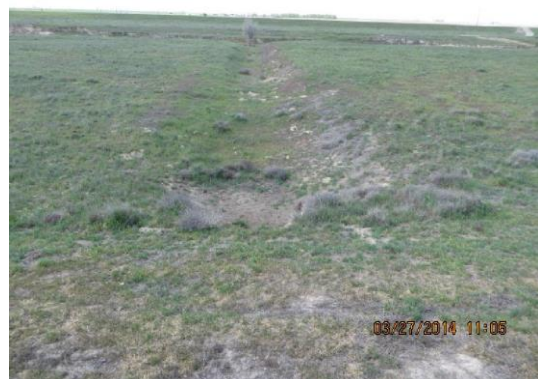
Photo 1 of 3 : UCIP\_SP\_2018\_39884\_59414.jpg

Comment Code						
Inspector Comment						
FS_ID:39884 DS_ID:19753 EP_NO: N/A Repair Type: Non-Urgent Crossing Status: Found UCIP Comments: Dense vegetation limits the inspector's visibility to identify signs of pipe failure (leaks) along the landward slope. Recommend removing vegetation along pipe alignment to conduct proper inspection of structure. Sediment buildup in pipe visible from landward side--recommend contacting owner to clear pipe. FIELD_STRUCT_DESC: 36-inch corrugated metal gravity drainage pipe through the levee, 10.2 feet below the crown. Flap gate on the waterside (WS) end. Concrete headwall on the landside (LS) end. Concrete U-shaped headwall on the WS end. [Additional Reference(s): DWR Levee Log, 2002. USACE San Joaquin O&M Manual 601.1, 1967, (HLM 29.49)]. FS Date: 3/27/2014

Concrete headwall on WS toe.

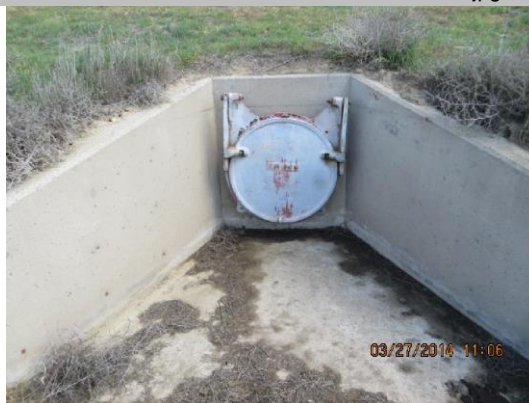
Photo 2 of 3 : UCIP\_SP\_2018\_39884\_59413.jpg

FS\_ID:39884  
DS\_ID:19753  
EP\_NO: N/A  
Repair Type: Non-Urgent  
Crossing Status: Found  
UCIP Comments: Dense vegetation limits the inspector's visibility to identify signs of pipe failure (leaks) along the landward slope. Recommend removing vegetation along pipe alignment to conduct proper inspection of structure. Sediment buildup in pipe visible from landward side--recommend contacting owner to clear pipe.  
FIELD\_STRUCT\_DESC: 36-inch corrugated metal gravity drainage pipe through the levee, 10.2 feet below the crown. Flap gate on the waterside (WS) end. Concrete headwall on the landside (LS) end. Concrete U-shaped headwall on the WS end. [Additional Reference(s): DWR Levee Log, 2002. USACE San Joaquin O&M Manual 601.1, 1967, (HLM 29.49)].  
FS Date: 3/27/2014

Flapgate on Concrete headwall at WS toe.

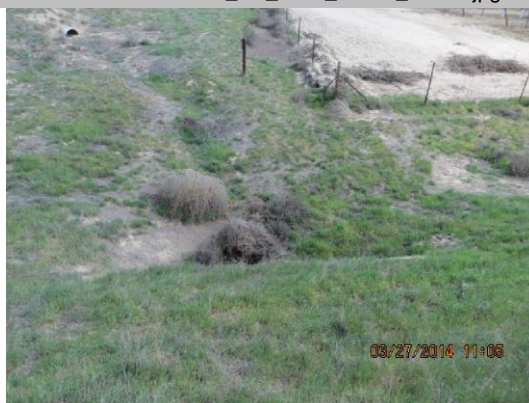
Photo 3 of 3 : UCIP\_SP\_2018\_39884\_59415.jpg

Concrete headwall on LS toe.

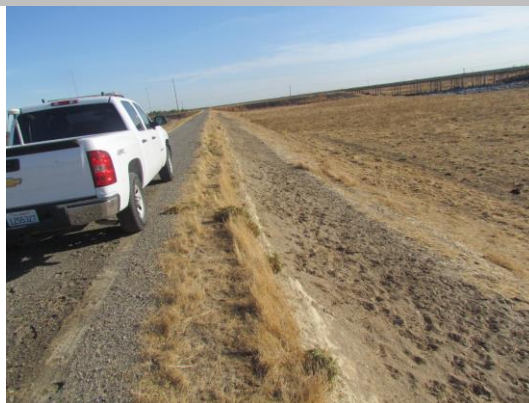
Photo 1 of 2 : SP\_2018\_NA0010\_123\_171\_20180307\_00035.jpg

LM Start	29.68	Rating **	M	Issue No.	171
LM End	29.80	Issue Type +	Ma	Location *	WS
Category	Earthen Levee			GPS Latitude/Longitude	
				Start	End
Item	Erosion / Bank Caving			37.020272 °	37.018712 °
				-120.433737 °	-120.432682 °
DWR ID	DWR_NA0010_05_s_2014_171				
Comment Code					
E1 : Note and monitor erosion site.					
Inspector Comment					
Waterside erosion caused by livestock.

Looking south at animal erosion on waterward slope.

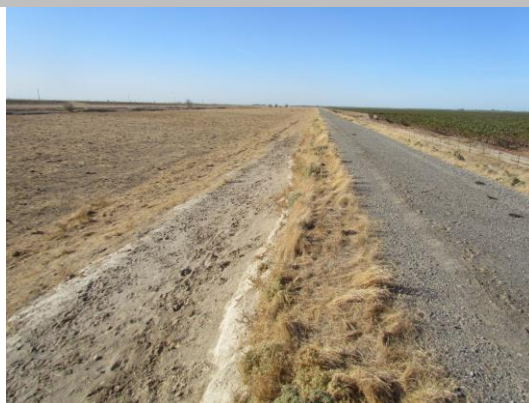
Photo 2 of 2 : SP\_2018\_NA0010\_123\_171\_20180307\_00036.jpg

Looking north at animal erosion on waterward slope.

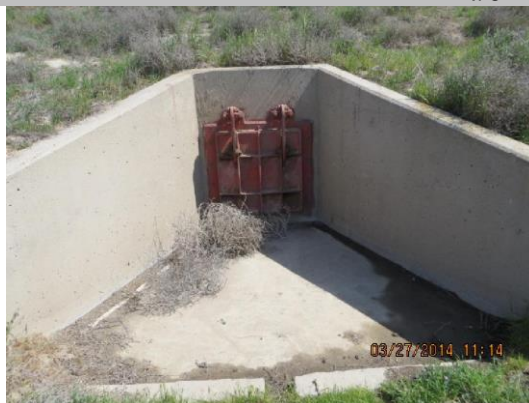
Photo 2 of 3 : UCIP\_SP\_2018\_39631\_59426.jpg

Flapgate on Concrete headwall at WS toe.

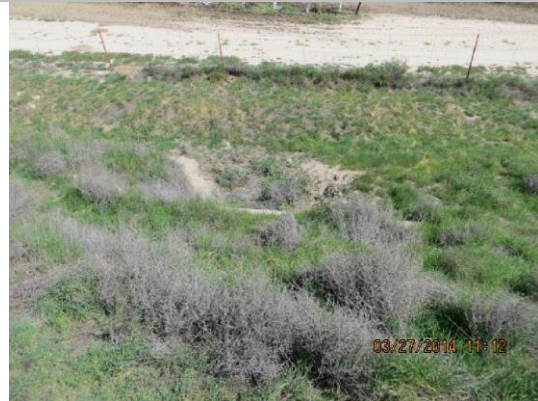
Photo 3 of 3 : UCIP\_SP\_2018\_39631\_59425.jpg

Item	DWR UCIP LMA Responsibility			37.018505 °	37.018505 °	
				-120.432544 °	-120.432544 °	
DWR ID						
Comment Code						
Inspector Comment						
FS_ID:39631						
DS_ID:19754						
EP_NO: N/A						
Repair Type: Non-Urgent						
Crossing Status: Found						
UCIP Comments: Dense vegetation limits the inspector's visibility to identify signs of pipe failure (leaks) along the landward slope.						
Recommend removing vegetation along pipe alignment to conduct proper inspection of structure.						
FIELD_STRUCT_DESC: 30-inch by 30-inch reinforced concrete box gravity drainage culvert through the levee, 12 feet below the crown. Flap gate on the waterside (WS) end. Concrete headwall on the landside (LS) end. Concrete U-shaped headwall on the WS end. [Additional Reference(s): DWR Levee Log, 2002. USACE San Joaquin O&M Manual 601.1, 1967, (HLM 29.72)].						
FS Date: 3/27/2014

Concrete headwall on LS toe.

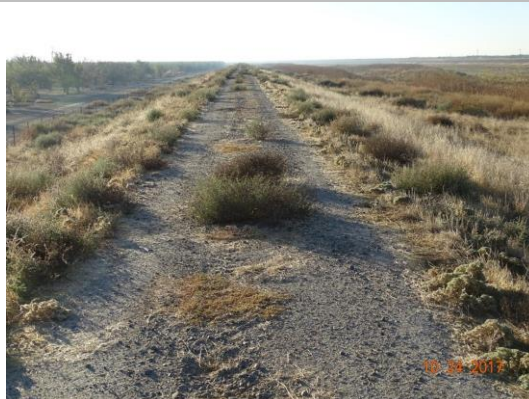
Photo 1 of 1 : SP\_2018\_NA0010\_123\_128\_20180307\_00033.jpg

LM Start	29.88	Rating **	A/W	Issue No.	128
LM End	31.19	Issue Type +	Ma	Location *	CR
Category	Earthen Levee			GPS Latitude/Longitude	
				Start	End
Item	Vegetation			37.017747 °	37.002885 °
				-120.432013 °	-120.417550 °
DWR ID	DWR_NA0010_05_f_2017_128				
Comment Code					
V9 : Keep the crown roadway free of vegetation.					
Inspector Comment

Looking southeast at the crown.

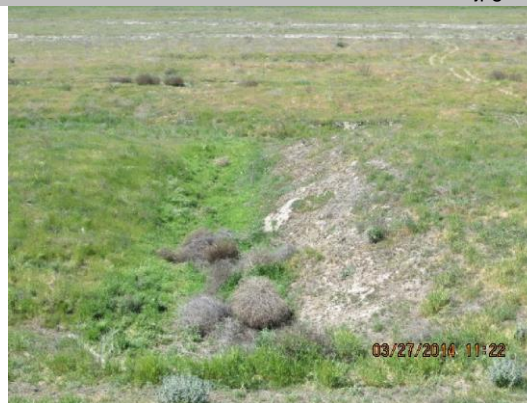
Photo 1 of 3 : UCIP\_SP\_2018\_39632\_59430.jpg

Comment Code					
Inspector Comment					
FS_ID:39632					
DS_ID:19696					
EP_NO: N/A					
Repair Type: Non-Urgent					
Crossing Status: Found					
UCIP Comments: Dense vegetation limits the inspector's visibility to identify signs of pipe failure (leaks) along the landward slope.					
Recommend removing vegetation along pipe alignment to conduct proper inspection of structure.					
FIELD_STRUCT_DESC: 30-inch by 30-inch reinforced concrete box gravity drainage culvert through the levee, 13.1 feet below the crown.					
Flap gate on the waterside (WS) end. Concrete headwall on the landside (LS) end. Concrete U-shaped headwall on the WS end.					
[Additional Reference(s): DWR Levee Log, 2002. USACE San Joaquin O&M Manual 601.1, 1967, (HLM 30.04)].					
FS Date: 3/27/2014

Concrete headwall on WS toe.

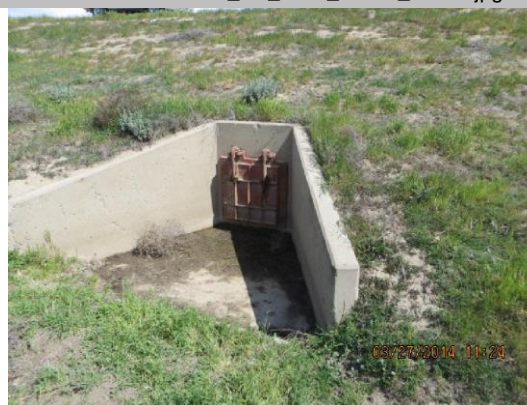
Photo 2 of 3 : UCIP\_SP\_2018\_39632\_59431.jpg

Flapgate on Concrete headwall at WS toe.

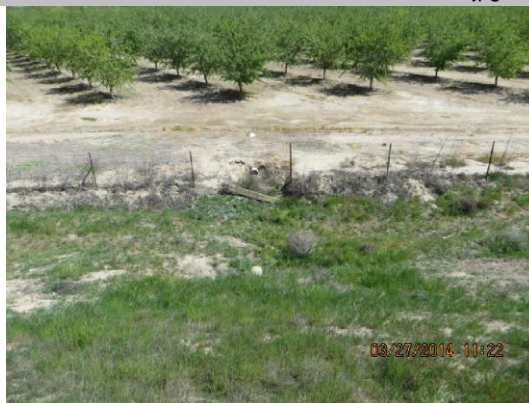
Photo 3 of 3 : UCIP\_SP\_2018\_39632\_59429.jpg

Item	DWR UCIP LMA Responsibility			37.014471 °	37.014471 °	
				-120.429759 °	-120.429759 °	
DWR ID						
Comment Code						
Inspector Comment						
FS_ID:39632						
DS_ID:19696						
EP_NO: N/A						
Repair Type: Non-Urgent						
Crossing Status: Found						
UCIP Comments: Dense vegetation limits the inspector's visibility to identify signs of pipe failure (leaks) along the landward slope.						
Recommend removing vegetation along pipe alignment to conduct proper inspection of structure.						
FIELD_STRUCT_DESC: 30-inch by 30-inch reinforced concrete box gravity drainage culvert through the levee, 13.1 feet below the crown.						
Flap gate on the waterside (WS) end. Concrete headwall on the landside (LS) end. Concrete U-shaped headwall on the WS end.						
[Additional Reference(s): DWR Levee Log, 2002. USACE San Joaquin O&M Manual 601.1, 1967, (HLM 30.04)].						
FS Date: 3/27/2014

Concrete headwall on LS toe.

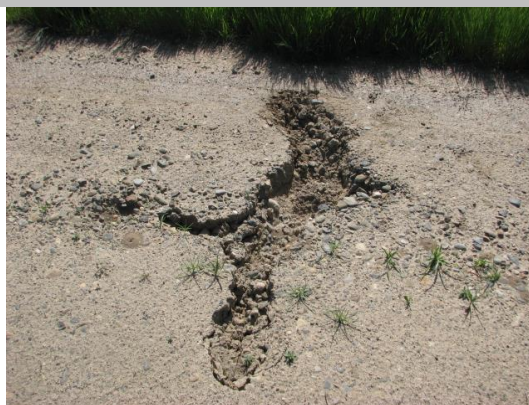
Photo 1 of 2 : SP\_2018\_NA0010\_123\_133\_20180411\_00312.jpg

LM Start	30.33	Rating **	M	Issue No.	133
LM End	30.33	Issue Type +	Ma	Location *	CR
Category	Earthen Levee			GPS Latitude/Longitude	
				Start	End
Item	Crown Surface / Depressions / Rutting			37.012070 °	37.012070 °
				-120.428101 °	-120.428101 °
DWR ID	DWR_NA0010_05_s_2018_133				
Comment Code					
C2 : Repair depressions or ruts in the crown or slope.					
Inspector Comment					
Minor depression on levee crown. Possible sink hole.

Looking east at depression on levee crown. (Spring 2018)

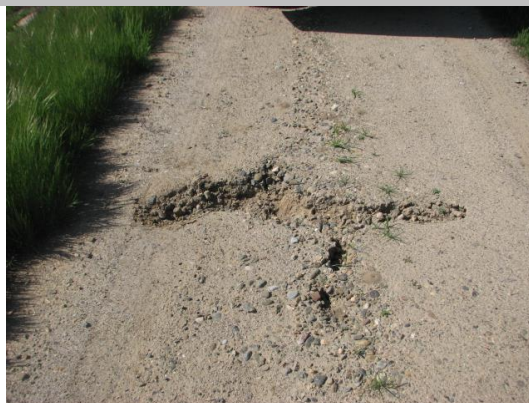
Photo 2 of 2 : SP\_2018\_NA0010\_123\_133\_20180411\_00313.jpg

LM Start	30.33	Rating **	M	Issue No.	133 (cont)
LM End	30.33	Issue Type +	Ma	Location *	CR
Category	Earthen Levee			GPS Latitude/Longitude	
				Start	End
Item	Crown Surface / Depressions / Rutting			37.012070 °	37.012070 °
				-120.428101 °	-120.428101 °
DWR ID	DWR_NA0010_05_s_2018_133				
Comment Code					
C2 : Repair depressions or ruts in the crown or slope.					
Inspector Comment					
Minor depression on levee crown. Possible sink hole.

Looking north at depression on levee crown. (Spring 2018)

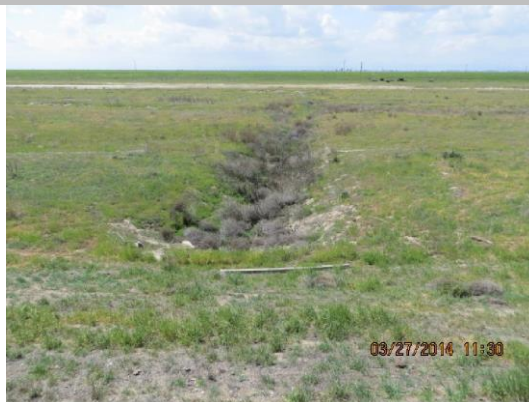
Photo 1 of 3 : UCIP\_SP\_2018\_39633\_59435.jpg

Comment Code					
Inspector Comment					
FS_ID:39633 DS_ID:19697 EP_NO: N/A Repair Type: Non-Urgent Crossing Status: Found UCIP Comments: Some debris buildup at LS toe. Dense vegetation limits the inspector's visibility to identify signs of pipe failure (leaks) along the landward slope. Recommend removing vegetation along pipe alignment to conduct proper inspection of structure. FIELD_STRUCT_DESC: 30-inch by 30-inch reinforced concrete box gravity drainage culvert through the levee, 13.3 feet below the crown. Flap gate on the waterside (WS) end. Concrete headwall on the landside (LS) end. Concrete U-shaped headwall on the WS end. [Additional Reference(s): DWR Levee Log, 2002. USACE San Joaquin O&M Manual 601.1, 1967, (HLM 30.96)]. FS Date: 3/27/2014

Concrete headwall on WS toe.

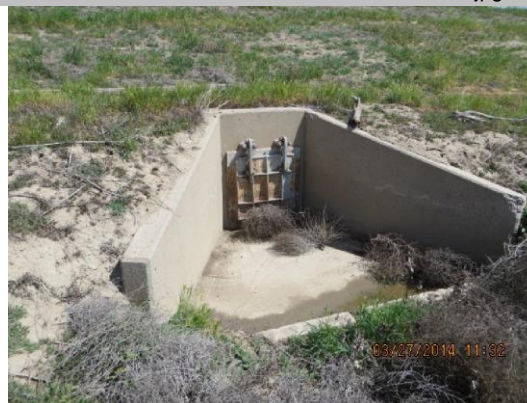
Photo 2 of 3 : UCIP\_SP\_2018\_39633\_59436.jpg

FS\_ID:39633  
DS\_ID:19697  
EP\_NO: N/A  
Repair Type: Non-Urgent  
Crossing Status: Found  
UCIP Comments: Some debris buildup at LS toe. Dense vegetation limits the inspector's visibility to identify signs of pipe failure (leaks) along the landward slope. Recommend removing vegetation along pipe alignment to conduct proper inspection of structure.  
FIELD\_STRUCT\_DESC: 30-inch by 30-inch reinforced concrete box gravity drainage culvert through the levee, 13.3 feet below the crown. Flap gate on the waterside (WS) end. Concrete headwall on the landside (LS) end. Concrete U-shaped headwall on the WS end.  
[Additional Reference(s): DWR Levee Log, 2002. USACE San Joaquin O&M Manual 601.1, 1967, (HLM 30.96)].  
FS Date: 3/27/2014

Flapgate on Concrete headwall at WS toe.

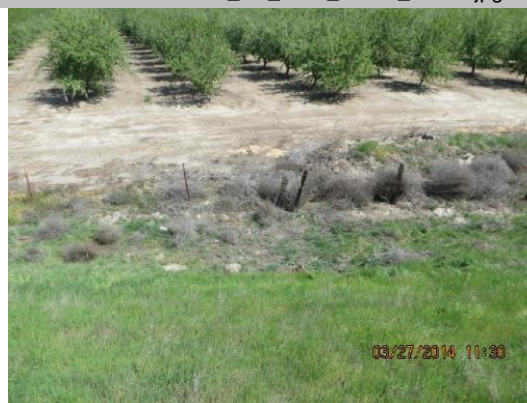
Photo 3 of 3 : UCIP\_SP\_2018\_39633\_59434.jpg

Concrete headwall on LS toe.

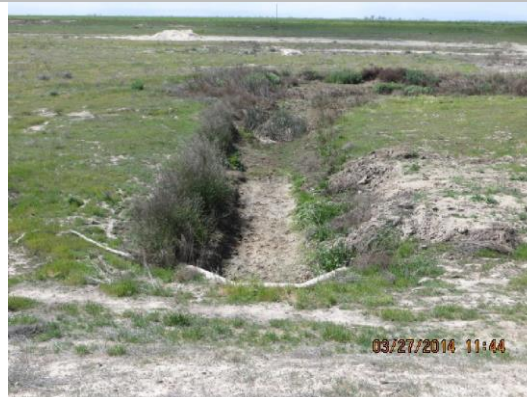
Photo 1 of 3 : UCIP\_SP\_2018\_39643\_59439.jpg

Comment Code					
Inspector Comment					
FS_ID:39643					
DS_ID:19698					
EP_NO: N/A					
Repair Type: Non-Urgent					
Crossing Status: Found					
UCIP Comments: Excess vegetation buildup at inlet on LS toe. Dense vegetation limits the inspector's visibility to identify signs of pipe failure (leaks) along the landward slope. Recommend removing vegetation along pipe alignment to conduct proper inspection of structure.					
FIELD_STRUCT_DESC: 30-inch by 30-inch reinforced concrete box gravity drainage culvert through the levee, 13.4 feet below the crown. Flap gate on the waterside (WS) end. Concrete headwall on the landside (LS) end. Concrete U-shaped headwall on the WS end.					
[Additional Reference(s): DWR Levee Log, 2002. USACE San Joaquin O&M Manual 601.1, 1967, (HLM 31.19)].					
FS Date: 3/27/2014

Concrete headwall on WS toe.

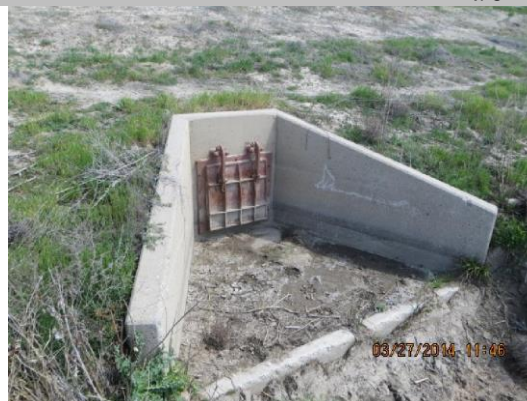
Photo 2 of 3 : UCIP\_SP\_2018\_39643\_59440.jpg

Flapgate at concrete headwall on WS toe.

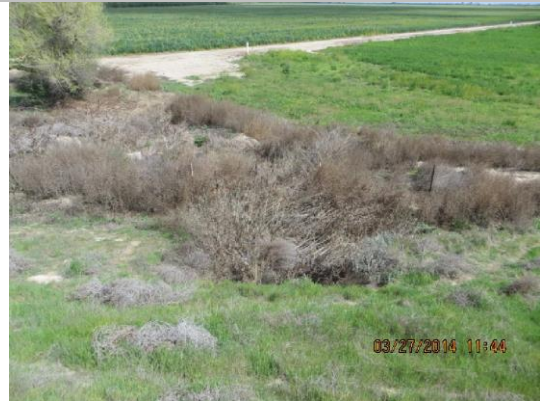
Photo 3 of 3 : UCIP\_SP\_2018\_39643\_59438.jpg

Item	DWR UCIP LMA Responsibility			37.001754 °	37.001754 °	
				-120.416254 °	-120.416254 °	
DWR ID						
Comment Code						
Inspector Comment						
FS_ID:39643 DS_ID:19698 EP_NO: N/A Repair Type: Non-Urgent Crossing Status: Found UCIP Comments: Excess vegetation buildup at inlet on LS toe. Dense vegetation limits the inspector's visibility to identify signs of pipe failure (leaks) along the landward slope. Recommend removing vegetation along pipe alignment to conduct proper inspection of structure. FIELD_STRUCT_DESC: 30-inch by 30-inch reinforced concrete box gravity drainage culvert through the levee, 13.4 feet below the crown. Flap gate on the waterside (WS) end. Concrete headwall on the landside (LS) end. Concrete U-shaped headwall on the WS end. [Additional Reference(s): DWR Levee Log, 2002. USACE San Joaquin O&M Manual 601.1, 1967, (HLM 31.19)]. FS Date: 3/27/2014

Concrete headwall on LS toe.

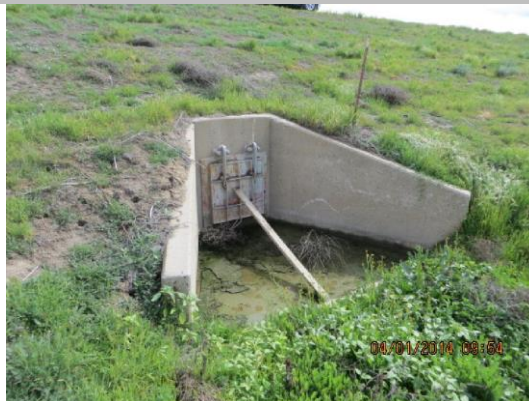
Photo 2 of 3 : UCIP\_SP\_2018\_39645\_59687.jpg

Flapgate on Concrete headwall at channel on WS toe.

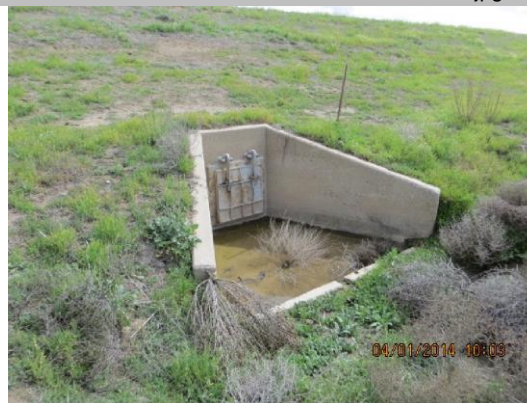
Photo 2 of 3 : UCIP\_SP\_2018\_39646\_59688.jpg

FS\_ID:39646  
DS\_ID:19701  
EP\_NO: N/A  
Repair Type: Non-Urgent  
Crossing Status: Found  
UCIP Comments: Some silt buildup inside culvert.  
FIELD\_STRUCT\_DESC: 30-inch by 30-inch reinforced concrete box gravity drainage culvert through the levee, 14.2 feet below the crown. Flap gate on the waterside (WS) end. Concrete headwall on the landside (LS) end with flashboard attachment. Concrete U-shaped headwall on the WS end. [Additional Reference(s): DWR Levee Log, 2002. USACE San Joaquin O&M Manual 601.1, 1967, (HLM 32.22)].  
FS Date: 4/1/2014

Flapgate on Concrete headwall at WS toe.

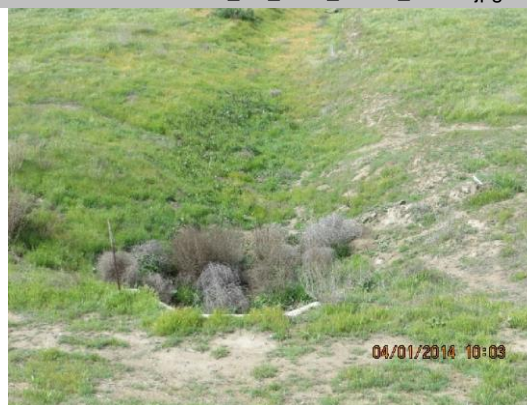
Photo 3 of 3 : UCIP\_SP\_2018\_39646\_59689.jpg

Concrete headwall at outlet on WS toe.

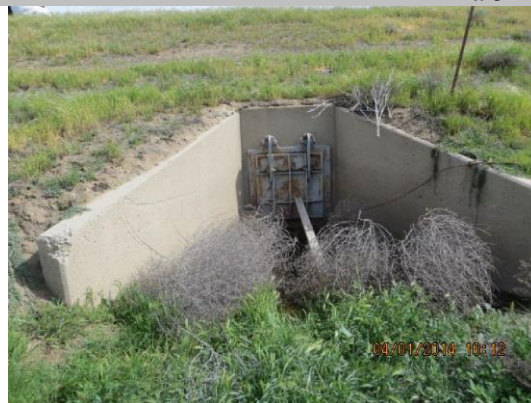
Photo 2 of 3 : UCIP\_SP\_2018\_39647\_59699.jpg

Flapgate on Concrete headwall at WS toe.

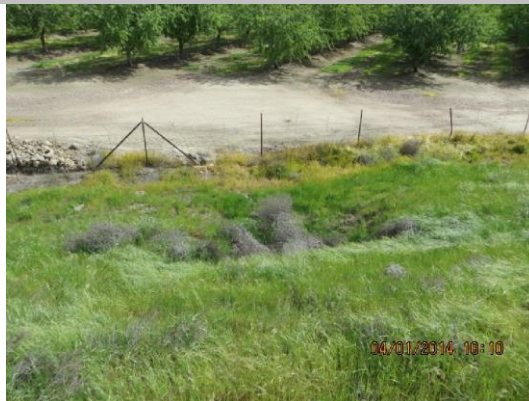
Photo 3 of 3 : UCIP\_SP\_2018\_39647\_59698.jpg

Concrete headwall at inlet on LS toe.

Comment Code					
Inspector Comment					
FS_ID:39647 DS_ID:19702 EP_NO: N/A Repair Type: Non-Urgent Crossing Status: Found UCIP Comments: Dense vegetation limits the inspector's visibility to identify signs of pipe failure (leaks) along the landward slope. Recommend removing vegetation along pipe alignment to conduct proper inspection of structure. Debris buildup blocking landward headwall--recommend contacting owner to clear debris. FIELD_STRUCT_DESC: 30-inch by 30-inch reinforced concrete box gravity drainage culvert through the levee, 12.2 feet below the crown. Flap gate on the waterside (WS) end. Concrete headwall on the landside (LS) end. Concrete U-shaped headwall on the WS end. [Additional Reference(s): DWR Levee Log, 2002. USACE San Joaquin O&M Manual 601.1, 1967, (HLM 33.01)]. FS Date: 4/1/2014

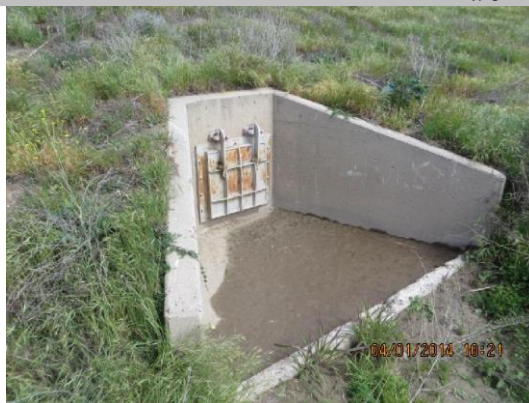
Photo 2 of 3 : UCIP\_SP\_2018\_39648\_59700.jpg

Flapgate on Concrete headwall at WS toe.
