**Flood Control Project Maintenance  
Levee Inspections**

## Maintenance Issue Types Only, Levee Inspection Report By Mile - Spring 2018

### Lower San Joaquin Levee District

Waterway	Bank	Unit Miles	Inspection Start/End	Inspector
Unit No. 01 San Joaquin River	Right	22.52	04/04/2018 04/16/2018	Richard Willoughby

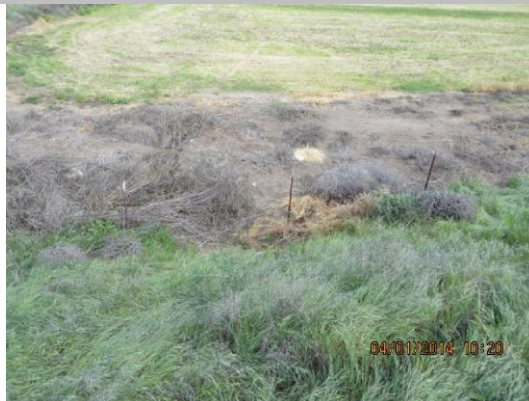
Photo 3 of 3 : UCIP\_SP\_2018\_39648\_59702.jpg

Item	DWR UCIP LMA Responsibility			36.976808 °	36.976808 °	
				-120.382593 °	-120.382593 °	
DWR ID						
Comment Code						
Inspector Comment						
FS_ID:39648 DS_ID:19703 EP_NO: N/A Repair Type: Non-Urgent Crossing Status: Found UCIP Comments: Dense vegetation limits the inspector's visibility to identify signs of pipe failure (leaks) along the slopes. Recommend removing vegetation along pipe alignment to conduct proper inspection of structure. FIELD_STRUCT_DESC: 30-inch by 30-inch reinforced concrete box gravity drainage culvert through the levee, 13.9 feet below the crown. Flap gate on the waterside (WS) end. Concrete headwall on the landside (LS) end. Concrete U-shaped headwall on the WS end. [Additional Reference(s): DWR Levee Log, 2002. USACE San Joaquin O&M Manual 601.1, 1967, (HLM 33.72)]. FS Date: 4/1/2014

Concrete headwall at LS toe.

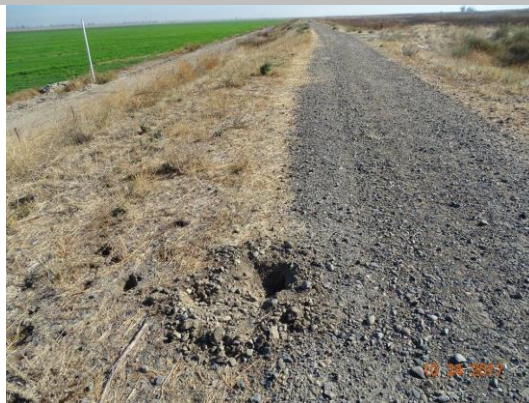
Photo 1 of 1 : SP\_2018\_NA0010\_123\_130\_20180307\_00034.jpg

LM Start	33.82	Rating **	M	Issue No.	130
LM End	33.82	Issue Type +	Ma	Location *	LS
Category	Earthen Levee			GPS Latitude/Longitude	
				Start	End
Item	Animal Control			36.976849 °	36.976849 °
				-120.382393 °	-120.382393 °
DWR ID	DWR_NA0010_05_f_2017_130				
Comment Code					
A3 : No rodents visible, but rodent burrows visible; need to backfill and compact or grout burrows.					
Inspector Comment

Looking east at the landside shoulder.

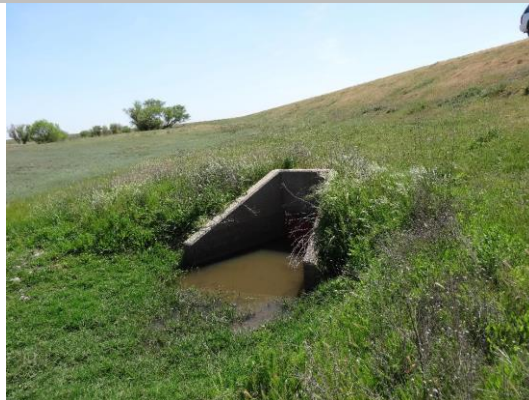
Photo 2 of 3 : UCIP\_SP\_2018\_36565\_66345.jpg

Concrete structure located on waterward toe.

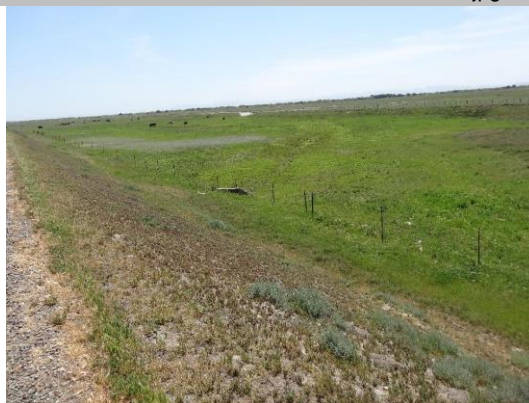
Photo 3 of 3 : UCIP\_SP\_2018\_36565\_66344.jpg

LM Start	0.78	Rating **	M	Issue No.	1214 (cont)	
LM End	0.78	Issue Type +	Ma	Location *		
Category	Supplemental			GPS Latitude/Longitude		
				Start		End
Item	DWR UCIP LMA Responsibility			37.270460 °		37.270460 °
				-120.814290 °		-120.814290 °
DWR ID						
Comment Code						
Inspector Comment						
FS_ID:36565 DS_ID:19816 EP_NO: N/A Repair Type: Non-Urgent Crossing Status: Found UCIP Comments: Landward side blocked--need to contact owner to determine status of crossing. FIELD_STRUCT_DESC: 24-inch corrugated metal gravity drainage pipe through the levee, 16.2 feet below the crown. Flap gate on the waterside (WS) end. Concrete U-shaped headwall on each end. [Additional Reference(s): DWR Levee Log, 2002. USACE San Joaquin O&M Manual 601.1, 1967, (HLM 0.86)]. FS Date: 4/18/2014

View of landward side.

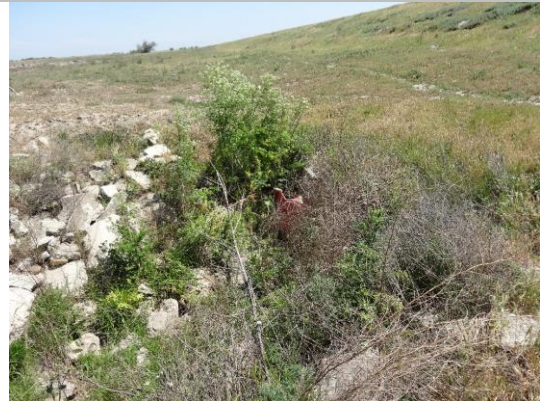
Photo 3 of 3 : UCIP\_SP\_2018\_36566\_66349.jpg

LM Start	1.87	Rating **	M	Issue No.	1215 (cont)	
LM End	1.87	Issue Type +	Ma	Location *		
Category	Supplemental			GPS Latitude/Longitude		
				Start	End	
Item	DWR UCIP LMA Responsibility			37.259312 °	37.259312 °	
				-120.802863 °	-120.802863 °	
DWR ID						
Comment Code						
Inspector Comment						
FS_ID:36566 DS_ID:19817 EP_NO: N/A Repair Type: Non-Urgent Crossing Status: Found UCIP Comments: No access was available to landward side due to fence. Recommend removing some of the vegetation on waterward toe. FIELD_STRUCT_DESC: 24-inch corrugated metal gravity drainage pipe through the levee, 13.5 feet below the crown. Flap gate on the waterside (WS) end. Concrete headwall on each end. [Additional Reference(s): DWR Levee Log, 2002. USACE San Joaquin O&M Manual 601.1, 1967, (HLM 1.95)]. FS Date: 4/18/2014

Flap gate visible on waterward side.

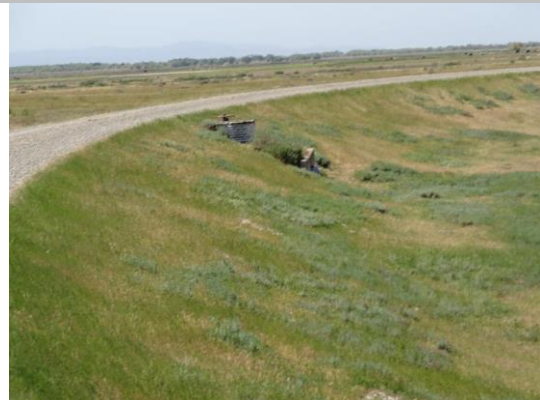
Photo 1 of 3 : UCIP\_SP\_2018\_39464\_66354.jpg

LM Start	2.53	Rating **	M	Issue No.	1216
LM End	2.53	Issue Type +	Ma	Location *	
Category	Supplemental			GPS Latitude/Longitude	
				Start	End
Item	DWR UCIP LMA Responsibility			37.252948 °	37.252948 °
				-120.794352 °	-120.794352 °
DWR ID					
Comment Code					
Inspector Comment					
FS_ID:39464 DS_ID:19818 EP_NO: N/A Repair Type: Non-Urgent Crossing Status: Found UCIP Comments: Need to contact owner. Sediment buildup in pipe visible on landward side. FIELD_STRUCT_DESC: 36-inch corrugated metal gravity drainage pipe through the levee, 6.9 feet below the crown. Slide gate in a 48-inch corrugated metal pipe (CMP) riser on the waterside (WS) slope. Concrete headwall on each end. [Additional Reference(s): DWR Levee Log, 2002. USACE San Joaquin O&M Manual 601.1, 1967, (HLM 2.61)]. FS Date: 4/18/2014

View of waterward side.

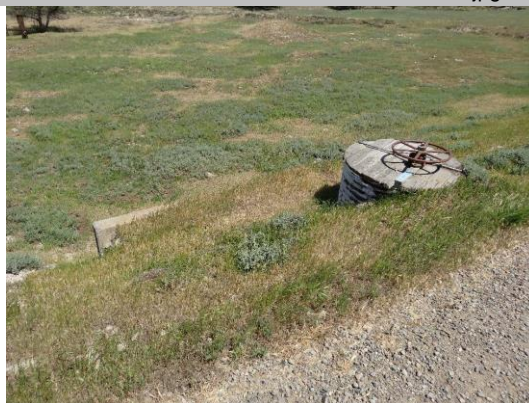
Photo 2 of 3 : UCIP\_SP\_2018\_39464\_66357.jpg

LM Start	2.53	Rating **	M	Issue No.	1216 (cont)	
LM End	2.53	Issue Type +	Ma	Location *		
Category	Supplemental			GPS Latitude/Longitude		
				Start		End
Item	DWR UCIP LMA Responsibility			37.252948 °		37.252948 °
				-120.794352 °		-120.794352 °
DWR ID						
Comment Code						
Inspector Comment						
FS_ID:39464 DS_ID:19818 EP_NO: N/A Repair Type: Non-Urgent Crossing Status: Found UCIP Comments: Need to contact owner. Sediment buildup in pipe visible on landward side. FIELD_STRUCT_DESC: 36-inch corrugated metal gravity drainage pipe through the levee, 6.9 feet below the crown. Slide gate in a 48-inch corrugated metal pipe (CMP) riser on the waterside (WS) slope. Concrete headwall on each end. [Additional Reference(s): DWR Levee Log, 2002. USACE San Joaquin O&M Manual 601.1, 1967, (HLM 2.61)]. FS Date: 4/18/2014

View of waterward side.

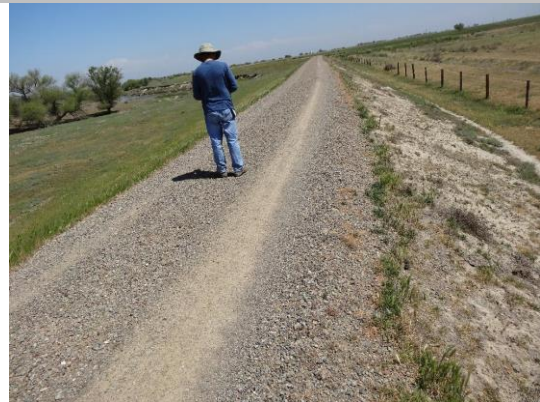
Photo 1 of 3 : UCIP\_SP\_2018\_36568\_66362.jpg

LM Start	<b>2.57</b>	Rating **	M	Issue No.	<b>1217</b>
LM End	<b>2.57</b>	Issue Type +	Ma	Location *	
Category	Supplemental		GPS Latitude/Longitude		
			Start	End	
Item	DWR UCIP LMA Responsibility		37.252743 °	37.252743 °	
			-120.793756 °	-120.793756 °	
DWR ID					
Comment Code					
Inspector Comment					
FS_ID:36568 DS_ID:19819 EP_NO: N/A Repair Type: Non-Urgent Crossing Status: Found UCIP Comments: Dense vegetation limits the inspector's visibility to identify signs of pipe condition on landward toe--headwall blocked by dense vegetation. Recommend removing vegetation from landward toe. FIELD_STRUCT_DESC: 24-inch corrugated metal gravity drainage pipe through the levee, 9.2 feet below the crown. Flap gate on the waterside (WS) end. Concrete headwall on each end. [Additional Reference(s): DWR Levee Log, 2002. USACE San Joaquin O&M Manual 601.1, 1967, (HLM 2.65)]. FS Date: 4/18/2014

Overview of levee crown at crossing.

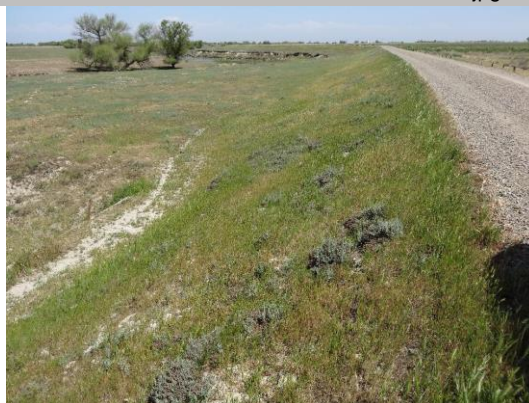
Photo 2 of 3 : UCIP\_SP\_2018\_36568\_66360.jpg

View of waterward side.

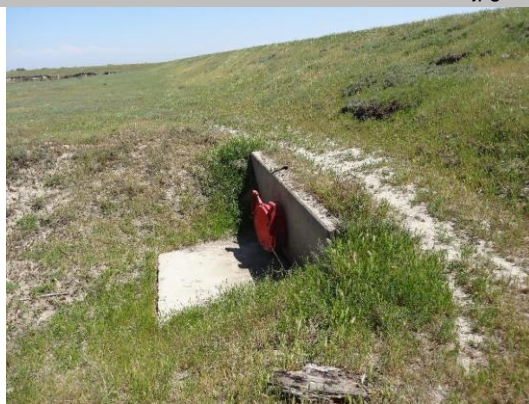
Photo 3 of 3 : UCIP\_SP\_2018\_36568\_66359.jpg

View of concrete headwall, flap gate, and concrete apron located on waterward side.

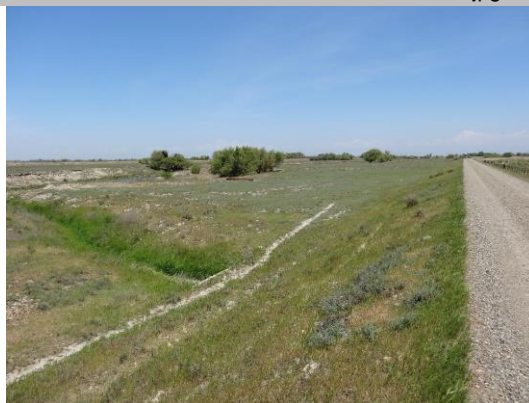
Photo 1 of 3 : UCIP\_SP\_2018\_36569\_66369.jpg

Comment Code						
Inspector Comment						
FS_ID:36569						
DS_ID:19820						
EP_NO: N/A						
Repair Type: Non-Urgent						
Crossing Status: Found						
UCIP Comments: Dense vegetation limits the inspector's visibility to identify signs of pipe condition on landward toe--headwall blocked by dense vegetation. Recommend removing vegetation from landward toe.						
FIELD_STRUCT_DESC: 24-inch corrugated metal gravity drainage pipe through the levee, 10.5 feet below the crown. Flap gate on the waterside (WS) end. Concrete headwall on each end. [Additional Reference(s): DWR Levee Log, 2002. USACE San Joaquin O&M Manual 601.1, 1967, (HLM 2.85)].						
FS Date: 4/18/2014

View of waterward side.

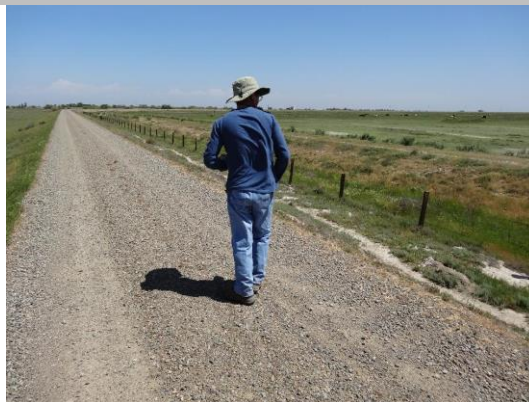
Photo 2 of 3 : UCIP\_SP\_2018\_36569\_66368.jpg

Overview of levee crown at crossing.

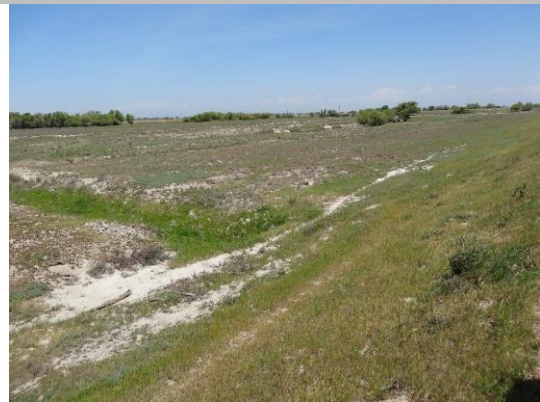
Photo 1 of 3 : UCIP\_SP\_2018\_36583\_66381.jpg

LM Start	3.01	Rating **	M	Issue No.	1219
LM End	3.01	Issue Type +	Ma	Location *	
Category	Supplemental			GPS Latitude/Longitude	
				Start	End
Item	DWR UCIP LMA Responsibility			37.253811 °	37.253811 °
				-120.786059 °	-120.786059 °
DWR ID					
Comment Code					
Inspector Comment					
FS_ID:36583 DS_ID:19821 EP_NO: N/A Repair Type: Non-Urgent Crossing Status: Found UCIP Comments: Dense vegetation limits the inspector's visibility to identify signs of pipe condition on landward toe--headwall blocked by dense vegetation. Recommend removing vegetation from landward toe. FIELD_STRUCT_DESC: 24-inch corrugated metal gravity drainage pipe through the levee, 11.2 feet below the crown. Flap gate on the waterside (WS) end. Concrete headwall on each end. [Additional Reference(s): DWR Levee Log, 2002. USACE San Joaquin O&M Manual 601.1, 1967, (HLM 3.09)]. FS Date: 4/18/2014

View of waterward side.

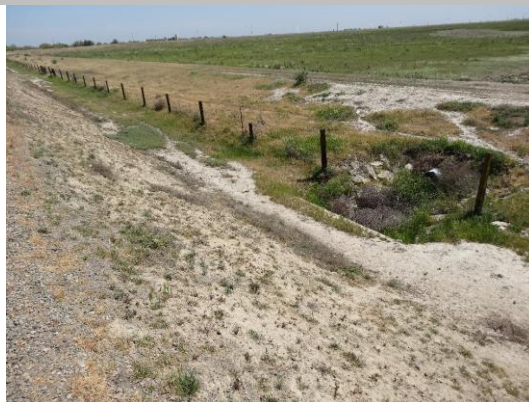
Photo 3 of 3 : UCIP\_SP\_2018\_36583\_66383.jpg

View of landward side.

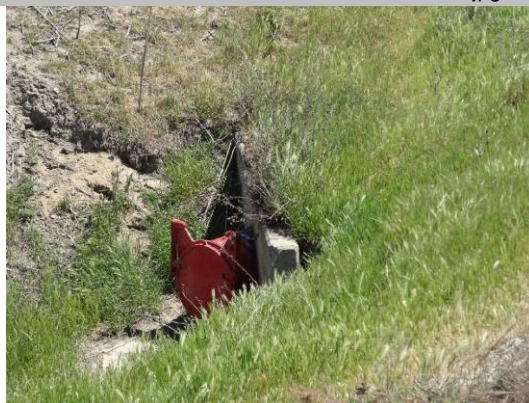
Photo 3 of 3 : UCIP\_SP\_2018\_36584\_66385.jpg

Comment Code						
Inspector Comment						
FS_ID:36584 DS_ID:19822 EP_NO: N/A Repair Type: Non-Urgent Crossing Status: Found UCIP Comments: Dense vegetation limits the inspector's visibility to identify signs of pipe condition on waterward slope and landward toe (headwall blocked by dense vegetation). Recommend removing vegetation from landward toe. FIELD_STRUCT_DESC: 24-inch corrugated metal gravity drainage pipe through the levee, 10.4 feet below the crown. Flap gate on the waterside (WS) end. Concrete headwall on each end. [Additional Reference(s): DWR Levee Log, 2002. USACE San Joaquin O&M Manual 601.1, 1967, (HLM 3.29)]. FS Date: 4/18/2014

Crossing goes through the levee at an angle. Flap gate visible on waterward side.

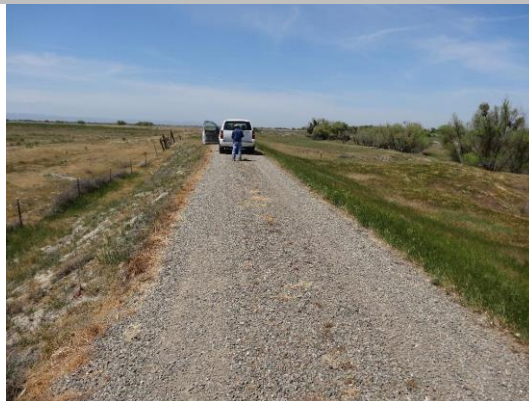
Photo 1 of 3 : UCIP\_SP\_2018\_36585\_66389.jpg

FS\_ID:36585  
DS\_ID:19823  
EP\_NO: N/A  
Repair Type: Non-Urgent  
Crossing Status: Found  
UCIP Comments: Alignment of crossing unknown--altered crossing. No headwall found on landward side only siphon breaker found a short distance from landward toe. Tall grass observed on waterward slope and some burrow activity also noticed. Need to contact owner to determine alignment of crossing and status of crossing.  
FIELD\_STRUCT\_DESC: 36-inch corrugated metal gravity drainage pipe through the levee, 15.7 feet below the crown. Flap gate on the waterside (WS) end. Concrete U-shaped headwall on each end. Bench mark (BM) stamped 9770-152 on top of the WS headwall. [Additional Reference(s): DWR Levee Log, 2002. USACE San Joaquin O&M Manual 601.1, 1967, (HLM 3.43)].  
FS Date: 4/18/2014

Overview of levee crown at crossing.

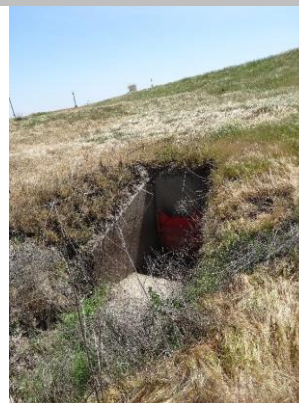
Photo 2 of 3 : UCIP\_SP\_2018\_36585\_66390.jpg

Flap gate and concrete headwall visible on waterward side.

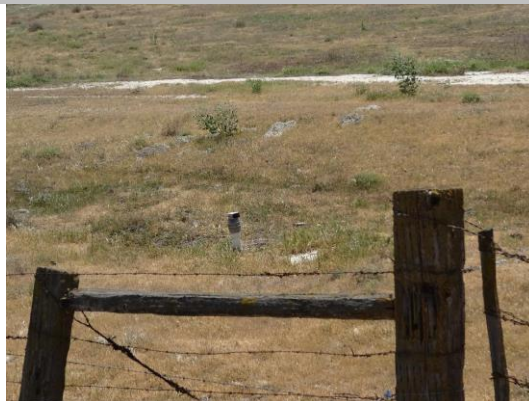
Photo 3 of 3 : UCIP\_SP\_2018\_36585\_66391.jpg

FS\_ID:36585  
DS\_ID:19823  
EP\_NO: N/A  
Repair Type: Non-Urgent  
Crossing Status: Found  
UCIP Comments: Alignment of crossing unknown--altered crossing. No headwall found on landward side only siphon breaker found a short distance from landward toe. Tall grass observed on waterward slope and some burrow activity also noticed. Need to contact owner to determine alignment of crossing and status of crossing.  
FIELD\_STRUCT\_DESC: 36-inch corrugated metal gravity drainage pipe through the levee, 15.7 feet below the crown. Flap gate on the waterside (WS) end. Concrete U-shaped headwall on each end. Bench mark (BM) stamped 9770-152 on top of the WS headwall. [Additional Reference(s): DWR Levee Log, 2002. USACE San Joaquin O&M Manual 601.1, 1967, (HLM 3.43)].  
FS Date: 4/18/2014

View of landward side. No signs of concrete headwall only siphon breaker visible on landward side.

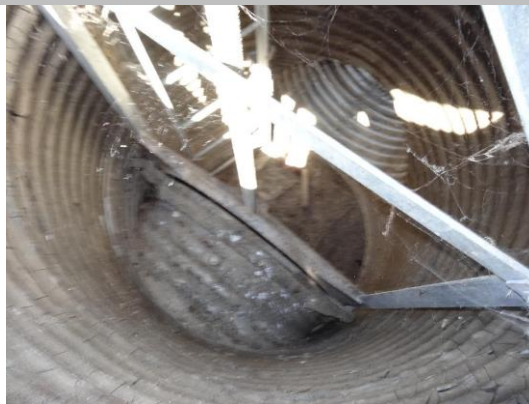
Photo 2 of 3 : UCIP\_SP\_2018\_39465\_66395.jpg

Inside view of cmp riser located on waterward slope.

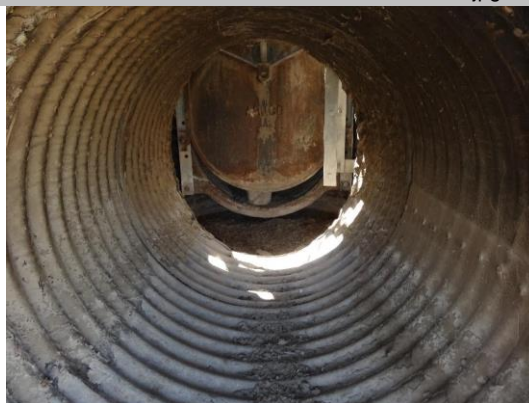
Photo 3 of 3 : UCIP\_SP\_2018\_39465\_66397.jpg

FS\_ID:39465  
DS\_ID:19825  
EP\_NO: N/A  
Repair Type: Non-Urgent  
Crossing Status: Found  
UCIP Comments: Sediment buildup inside pipe visible from landward side. Excess soil is also present on landward toe partially blocking concrete headwall and inlet. Recommend removing soil from landward toe and clear buildup inside.  
FIELD\_STRUCT\_DESC: 36-inch corrugated metal gravity drainage pipe through the levee, 6.8 feet below the crown. Slide gate in a 48-inch corrugated metal pipe (CMP) riser on the waterside (WS) slope. Concrete headwall on each end. Pipe connects to a 30-inch steel drainage pipe on the WS. Drainage pipe extends to the pump on the WS on a support platform in the channel. (Extension drainage pipe and pump installed under Permit No. 12527, 1979 - Joseph Gallo).  
[Additional Reference(s): DWR Levee Log, 2002. USACE San Joaquin O&M Manual 601.1, 1967, (HLM 3.54)].  
FS Date: 4/18/2014

Inside view of pipe from waterward side.

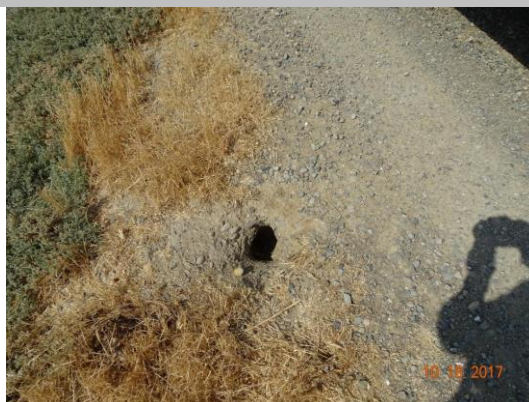
Photo 1 of 1 : SP\_2018\_NA0010\_124\_67\_20180307\_00017.jpg

LM Start	3.49	Rating **	M	Issue No.	67
LM End	3.49	Issue Type +	Ma	Location *	LS
Category	Earthen Levee			GPS Latitude/Longitude	
				Start	End
Item	Animal Control			37.251602 °	37.251602 °
				-120.778118 °	-120.778118 °
DWR ID	DWR NA0010 06 f 2017 67

Looking east at the landside slope.

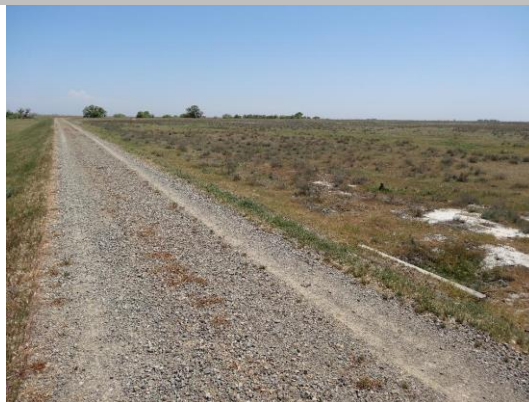
Photo 2 of 3 : UCIP\_SP\_2018\_39466\_66412.jpg

View of landward side.

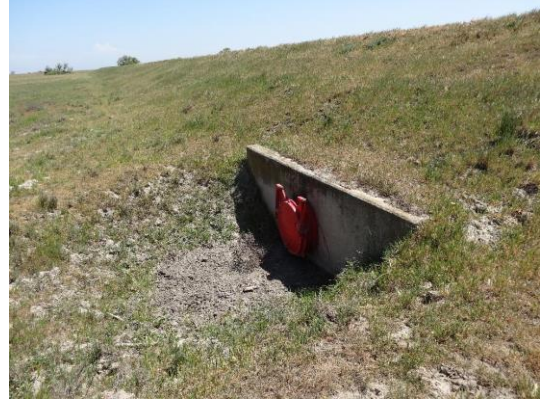
Photo 3 of 3 : UCIP\_SP\_2018\_39466\_66411.jpg

View of flap gate visible on waterward side.

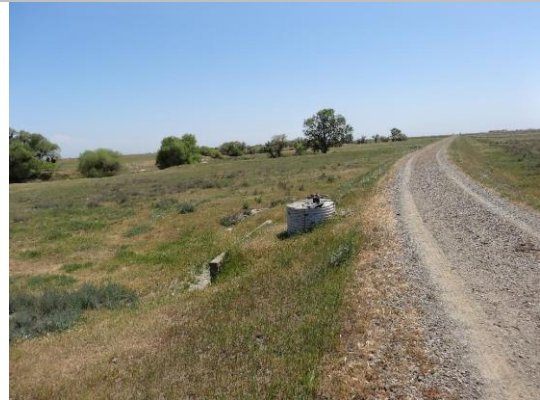
Photo 1 of 3 : UCIP\_SP\_2018\_39467\_66407.jpg

Comment Code					
Inspector Comment					
FS_ID:39467					
DS_ID:19827					
EP_NO: N/A					
Repair Type: Non-Urgent					
Crossing Status: Found					
UCIP Comments: Sediment buildup inside crossing and is visible from landward side. Recommend clearing sediment buildup inside pipe and check wall integrity to determine condition.					
FIELD_STRUCT_DESC: 36-inch corrugated metal gravity drainage pipe through the levee, 6.7 feet below the crown. Slide gate in a 48-inch corrugated metal pipe (CMP) riser on the waterside (WS) slope.					
[Additional Reference(s): DWR Levee Log, 2002. USACE San Joaquin O&M Manual 601.1, 1967, (HLM 3.97)].					
FS Date: 4/18/2014

View of waterward side.

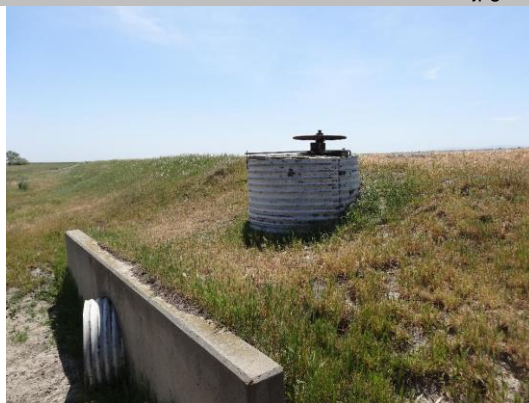
Photo 2 of 3 : UCIP\_SP\_2018\_39467\_66406.jpg

Slide gate inside CMP riser visible on waterward slope.

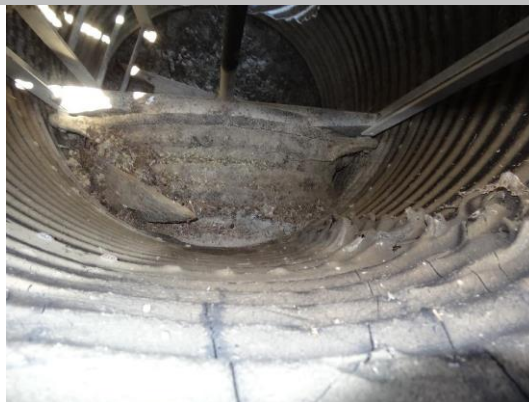
Photo 3 of 3 : UCIP\_SP\_2018\_39467\_66410.jpg

Inside view of CMP riser located on waterward side.

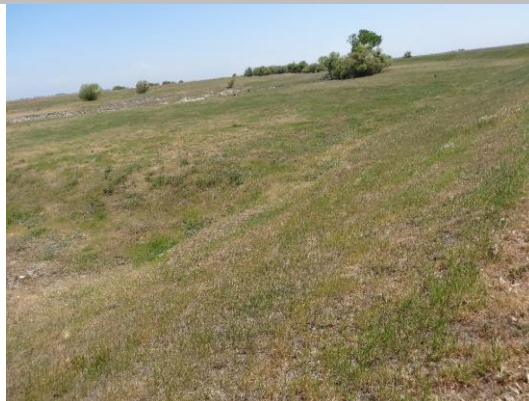
Photo 1 of 3 : UCIP\_SP\_2018\_36606\_66418.jpg

LM Start	4.09	Rating **	M	Issue No.	1226
LM End	4.09	Issue Type +	Ma	Location *	
Category	Supplemental			GPS Latitude/Longitude	
				Start	End
Item	DWR UCIP LMA Responsibility			37.248353 °	37.248353 °
				-120.768922 °	-120.768922 °
DWR ID					
Comment Code					
Inspector Comment					
FS_ID:36606 DS_ID:19828 EP_NO: N/A Repair Type: Non-Urgent Crossing Status: Found UCIP Comments: Dense vegetation limits the inspector's visibility to identify signs of pipe condition on landward toe--headwall blocked by dense vegetation. Recommend removing vegetation from landward toe. FIELD_STRUCT_DESC: 24-inch corrugated metal gravity drainage pipe through the levee, 10.8 feet below the crown. Flap gate on the waterside (WS) end. Concrete headwall on each end. [Additional Reference(s): DWR Levee Log, 2002. USACE San Joaquin O&M Manual 601.1, 1967, (HLM 4.17)]. FS Date: 4/18/2014

View of waterward side.

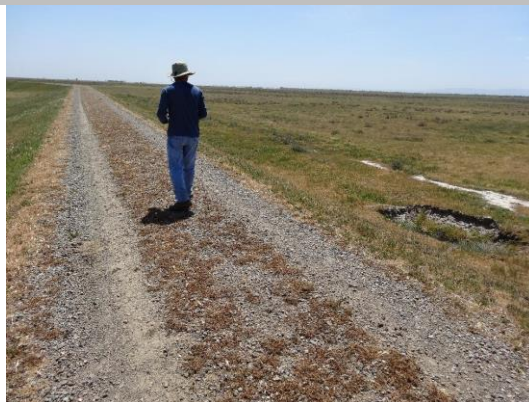
Photo 2 of 3 : UCIP\_SP\_2018\_36606\_66417.jpg

Overview of levee crown at crossing.

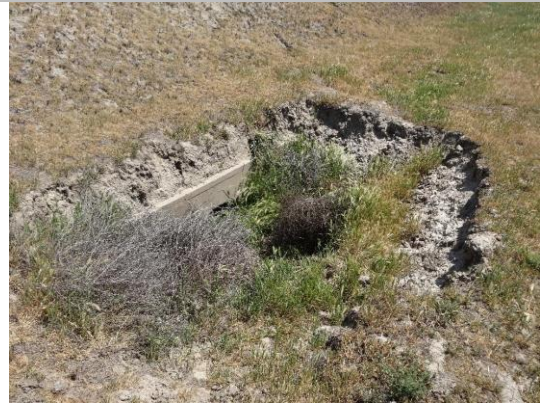
Photo 3 of 3 : UCIP\_SP\_2018\_36606\_66416.jpg

Concrete headwall visible on landward side.

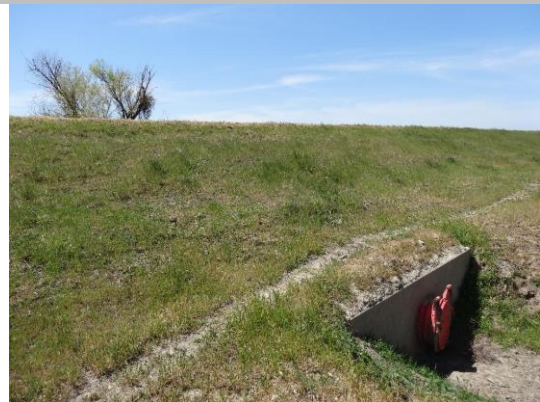
Photo 1 of 2 : UCIP\_SP\_2018\_36607\_66422.jpg

LM Start	4.33	Rating **	M	Issue No.	1227
LM End	4.33	Issue Type +	Ma	Location *	
Category	Supplemental			GPS Latitude/Longitude	
				Start	End
Item	DWR UCIP LMA Responsibility			37.246459 °	37.246459 °
				-120.765470 °	-120.765470 °
DWR ID					
Comment Code					
Inspector Comment					
FS_ID:36607 DS_ID:19829 EP_NO: N/A Repair Type: Non-Urgent Crossing Status: Found UCIP Comments: Dense vegetation limits the inspector's visibility to identify signs of pipe condition on landward toe--headwall blocked by dense vegetation. Recommend removing vegetation from landward toe. FIELD_STRUCT_DESC: 24-inch corrugated metal gravity drainage pipe through the levee, 11.3 feet below the crown. Flap gate on the waterside (WS) end. Concrete headwall on each end. [Additional Reference(s): DWR Levee Log, 2002. USACE San Joaquin O&M Manual 601.1, 1967, (HLM 4.41)]. FS Date: 4/18/2014

View of waterward side--concrete headwall and flap gate visible.

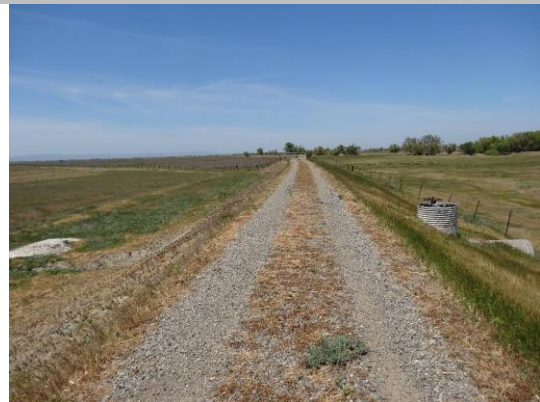
Photo 1 of 3 : UCIP\_SP\_2018\_39468\_66425.jpg

Comment Code						
Inspector Comment						
FS_ID:39468 DS_ID:19830 EP_NO: N/A Repair Type: Non-Urgent Crossing Status: Found UCIP Comments: Sediment buildup inside crossing visible from landward side. Recommend clearing sediment buildup inside pipe and check wall integrity to determine condition. FIELD_STRUCT_DESC: 36-inch corrugated metal gravity drainage pipe through the levee, 6.9 feet below the crown. Slide gate in a 48-inch corrugated metal pipe (CMP) riser on the waterside (WS) slope. Concrete headwall on the landside (LS) end. Concrete saddle and apron on the WS end. [Additional Reference(s): DWR Levee Log, 2002. USACE San Joaquin O&M Manual 601.1, 1967, (HLM 4.70)]. FS Date: 4/18/2014

Overview of levee crown at crossing.

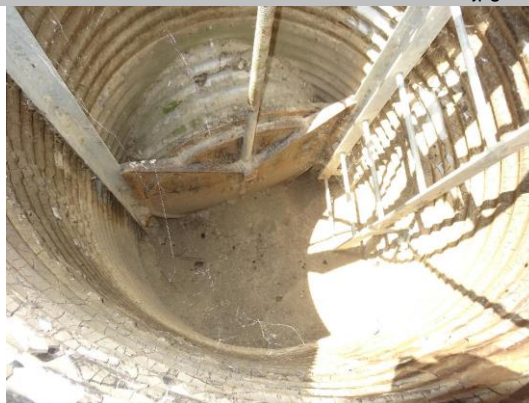
Photo 2 of 3 : UCIP\_SP\_2018\_39468\_66426.jpg

Inside view of CMP riser located on waterward.

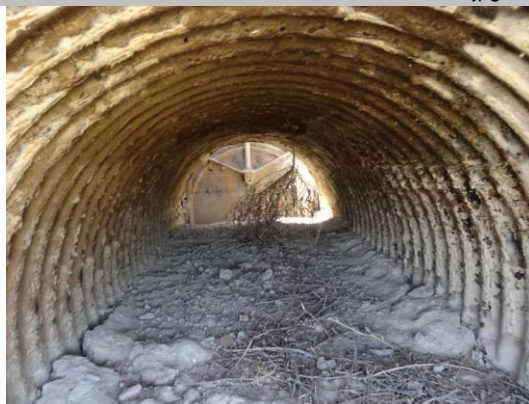
Photo 3 of 3 : UCIP\_SP\_2018\_39468\_66424.jpg

Inside view of pipe from waterward side.

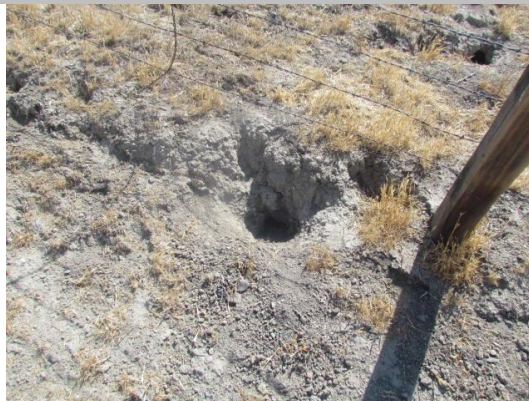
Photo 1 of 2 : SP\_2018\_NA0010\_124\_10\_20180307\_00012.jpg

LM Start	4.66	Rating **	M	Issue No.	10
LM End	4.66	Issue Type +	Ma	Location *	LS
Category	Earthen Levee			GPS Latitude/Longitude	
				Start	End
Item	Animal Control			37.243540 °	37.243540 °
				-120.760782 °	-120.760782 °
DWR ID	DWR_NA0010_06_s_2012_10				
Comment Code					
A3 : No rodents visible, but rodent burrows visible; need to backfill and compact or grout burrows.					
Inspector Comment					
Rodent holes next to fence post on landside slope.

Looking at rodent hole along fence line on landward slope.

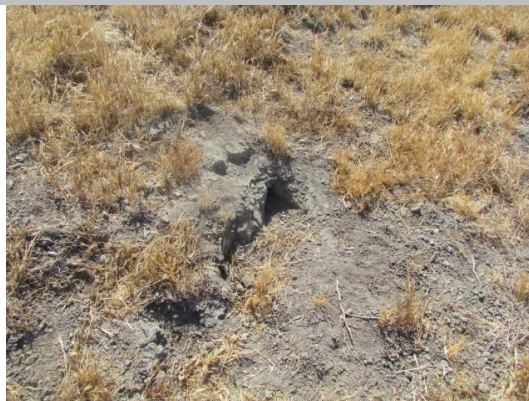
Photo 2 of 2 : SP\_2018\_NA0010\_124\_10\_20180307\_00013.jpg

Looking at typical rodent holes on landward slope.

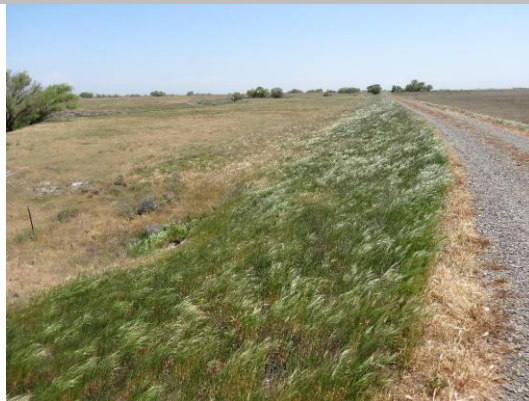
Photo 1 of 3 : UCIP\_SP\_2018\_36609\_66433.jpg

LM Start	4.67	Rating **	M	Issue No.	1229
LM End	4.67	Issue Type +	Ma	Location *	
Category	Supplemental			GPS Latitude/Longitude	
				Start	End
Item	DWR UCIP LMA Responsibility			37.243408 °	37.243408 °
				-120.760564 °	-120.760564 °
DWR ID					
Comment Code					
Inspector Comment					
FS_ID:36609					
DS_ID:19831					
EP_NO: N/A					
Repair Type: Non-Urgent					
Crossing Status: Found					
UCIP Comments: Need to contact owner. Recommend removing tall grass on landward toe to determine condition of crossing from landward side.					
FIELD_STRUCT_DESC: 24-inch corrugated metal gravity drainage pipe through the levee, 11.8 feet below the crown. Flap gate on the waterside (WS) end. Concrete headwall on each end. [Additional Reference(s): DWR Levee Log, 2002. USACE San Joaquin O&M Manual 601.1, 1967, (HLM 4.75)].					
FS Date: 4/18/2014

View of waterward side.

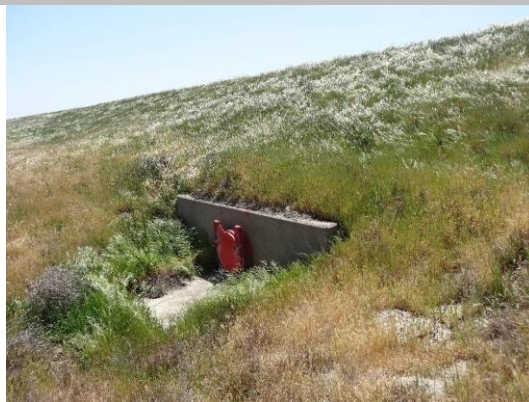
Photo 2 of 3 : UCIP\_SP\_2018\_36609\_66432.jpg

Flap gate, concrete headwall and apron visible on waterward toe.

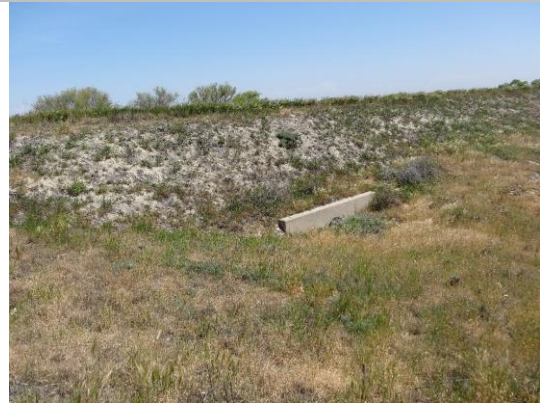
Photo 3 of 3 : UCIP\_SP\_2018\_36609\_66431.jpg

View of landward side.

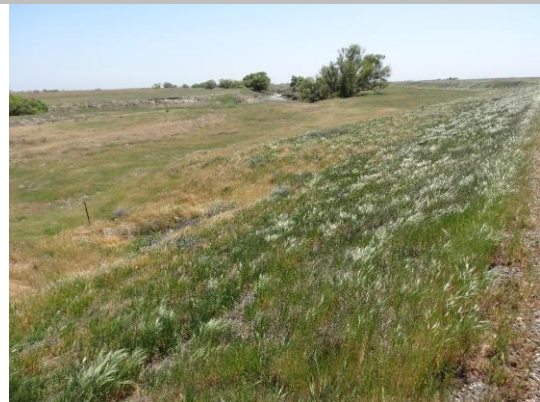
Photo 1 of 3 : UCIP\_SP\_2018\_36610\_66436.jpg

Comment Code						
Inspector Comment						
FS_ID:36610 DS_ID:19862 EP_NO: N/A Repair Type: Non-Urgent Crossing Status: Found UCIP Comments: Dense vegetation limits the inspector's visibility to identify signs of pipe failure (leaks) along the waterward slope. Recommend removing vegetation along waterward slope to conduct proper inspection of structure. Also recommend removing dense vegetation blocking landward headwall. FIELD_STRUCT_DESC: 24-inch corrugated metal gravity drainage pipe through the levee, 10.8 feet below the crown. Flap gate on the waterside (WS) end. Concrete headwall on each end. [Additional Reference(s): DWR Levee Log, 2002. USACE San Joaquin O&M Manual 601.1, 1967, (HLM 4.94)]. FS Date: 4/18/2014

View of waterward side.

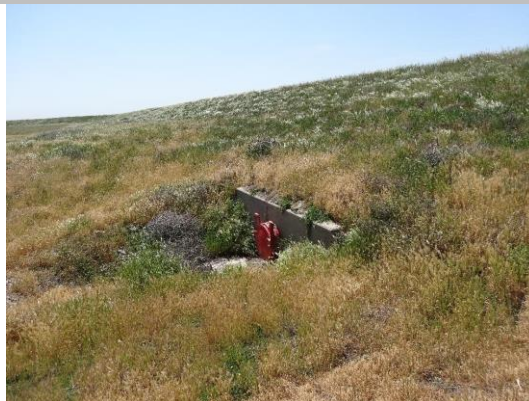
Photo 2 of 3 : UCIP\_SP\_2018\_36610\_66438.jpg

View of flap gate, concrete headwall and apron located on waterward side.

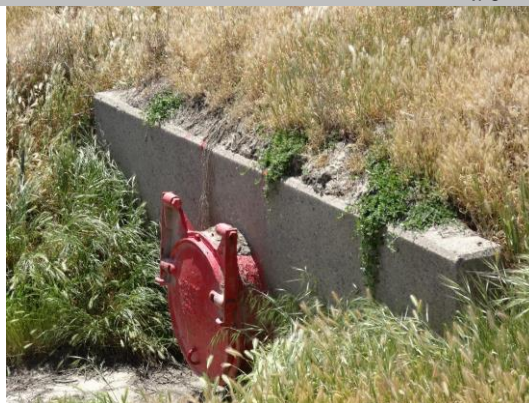
Photo 3 of 3 : UCIP\_SP\_2018\_36610\_66437.jpg

Close up of flap gate located on waterward side.

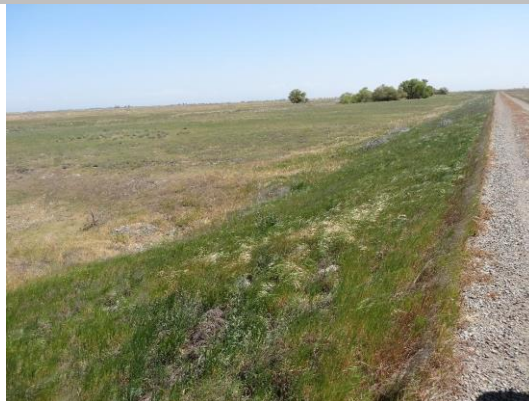
Photo 1 of 3 : UCIP\_SP\_2018\_39875\_61599.jpg

LM Start	5.26	Rating **	M	Issue No.	1231
LM End	5.26	Issue Type +	Ma	Location *	
Category	Supplemental			GPS Latitude/Longitude	
				Start	End
Item	DWR UCIP LMA Responsibility			37.239098 °	37.239098 °
				-120.751774 °	-120.751774 °
DWR ID					
Comment Code					
Inspector Comment					
FS_ID:39875 DS_ID:19863 EP_NO: N/A Repair Type: Non-Urgent Crossing Status: Found UCIP Comments: Clear vegetation from waterward slope and landward headwall. FIELD_STRUCT_DESC: 24-inch corrugated metal gravity drainage pipe through the levee, 10.9 feet below the crown. Flap gate on the waterside (WS) end. Concrete headwall on each end. [Additional Reference(s): DWR Levee Log, 2002. USACE San Joaquin O&M Manual 601.1, 1967, (HLM 5.34)]. FS Date: 4/18/2014

View of waterward side.

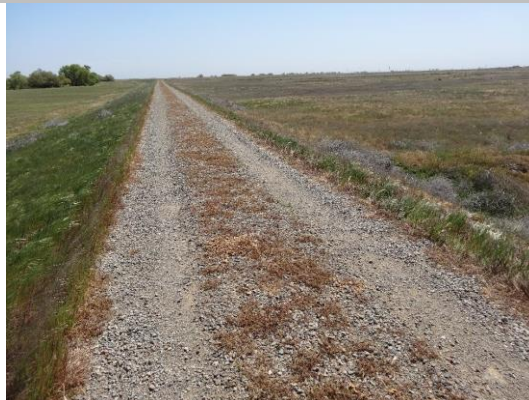
Photo 2 of 3 : UCIP\_SP\_2018\_39875\_61598.jpg

Overview of levee crown at crossing.

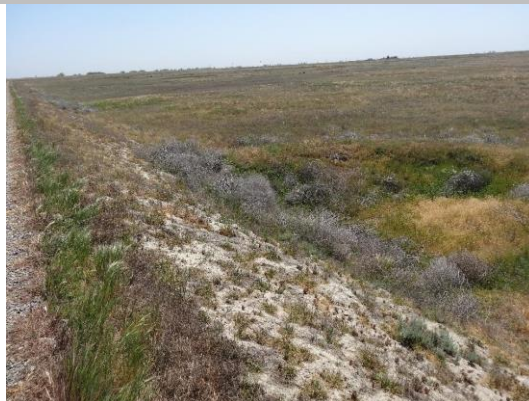
Photo 3 of 3 : UCIP\_SP\_2018\_39875\_61597.jpg

View of landward side.

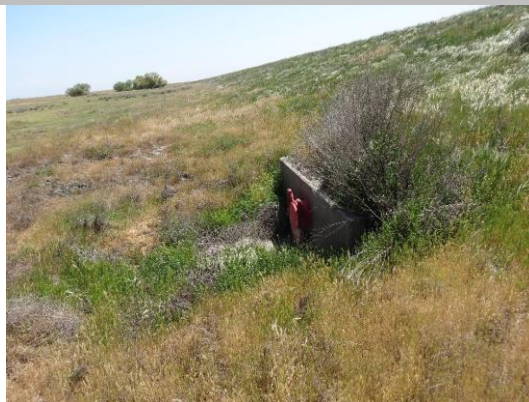
Photo 1 of 3 : UCIP\_SP\_2018\_36611\_66441.jpg

Comment Code					
Inspector Comment					
FS_ID:36611 DS_ID:19864 EP_NO: N/A Repair Type: Non-Urgent Crossing Status: Found UCIP Comments: Dense vegetation limits the inspector's visibility to identify signs of pipe failure (leaks) along the waterward slope. Recommend removing vegetation along pipe alignment to conduct proper inspection of structure. Also recommend removing excess vegetation at landward headwall. FIELD_STRUCT_DESC: 24-inch corrugated metal gravity drainage pipe through the levee, 11 feet below the crown. Flap gate on the waterside (WS) end. Concrete headwall on each end. [Additional Reference(s): DWR Levee Log, 2002. USACE San Joaquin O&M Manual 601.1, 1967, (HLM 5.63)]. FS Date: 4/18/2014

Concrete headwall and flap gate visible on waterward toe.

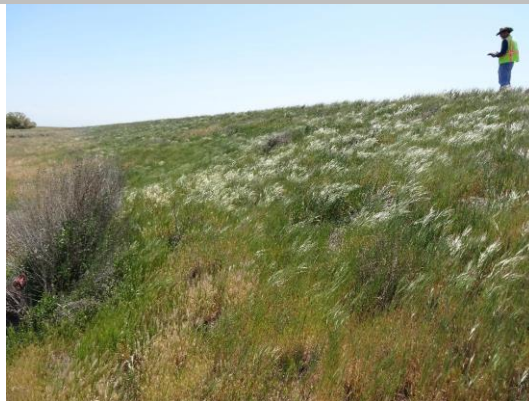
Photo 2 of 3 : UCIP\_SP\_2018\_36611\_66440.jpg

View of waterward side--dense vegetation covers slope.

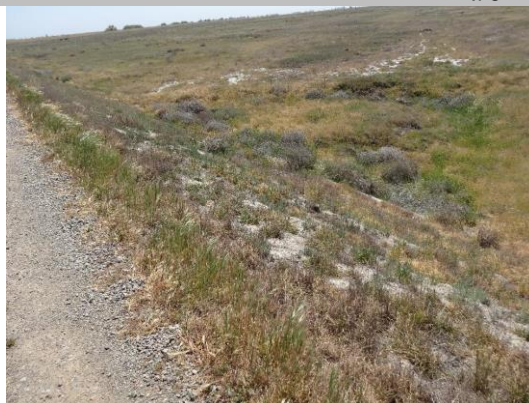
Photo 3 of 3 : UCIP\_SP\_2018\_36611\_66439.jpg

View of landward side.

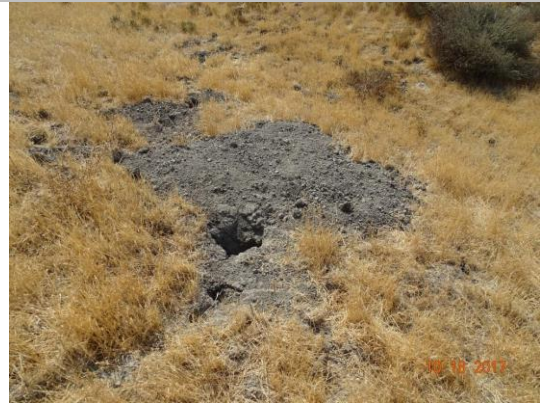
Photo 1 of 1 : SP\_2018\_NA0010\_124\_66\_20180307\_00016.jpg

LM Start	5.81	Rating **	U	Issue No.	66
LM End	5.81	Issue Type +	Ma	Location *	LS
Category	Earthen Levee			GPS Latitude/Longitude	
				Start	End
Item	Animal Control			37.238189 °	37.238189 °
				-120.741946 °	-120.741946 °
DWR ID	DWR_NA0010_06_f_2017_66				
Comment Code					
A3 : No rodents visible, but rodent burrows visible; need to backfill and compact or grout burrows.					
Inspector Comment

Looking southwest at the landside slope.

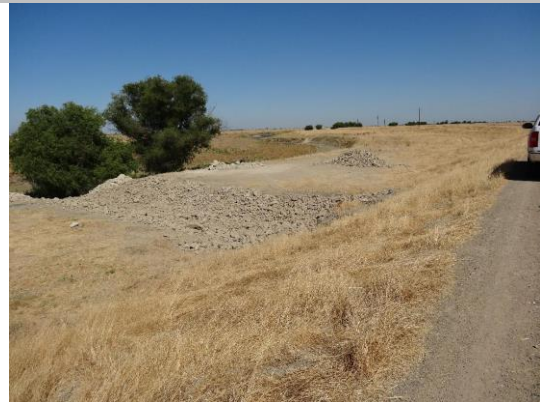
Photo 1 of 3 : UCIP\_SP\_2018\_51312\_75493.jpg

Comment Code					
Inspector Comment					
FS_ID:51312 DS_ID:19865 EP_NO: N/A Repair Type: No Action Needed Crossing Status: Found UCIP Comments: 7/19/2016 Site has been repaired on WS and LS (see photos below). (DWR UCIP - omagana)5/26/2016 Erosion is undermining the WS headwall of drainage structure (photos of WS headwall provided by DWR Inspector R. Willoughby). Potential pipe failure at the outlet just behind headwall, recommend completing internal wall integrity of pipe length through levee to determine extent of damage to pipe. (DWR UCIP - omagana)4/18/2014 Need to contact owner. Sediment buildup in pipe visible on landside--recommend clearing. (DWR UCIP - omagana) FIELD_STRUCT_DESC: 24-inch corrugated metal gravity drainage pipe through the levee, 9 feet below the crown. Flap gate on the waterside (WS) end. Concrete headwall on each end. [Additional Reference(s): DWR Levee Log, 2002. USACE San Joaquin O&M Manual 601.1, 1967, (HLM 6.06)]. FS Date: 7/19/2016

View of WS--rock protection along drainage path.

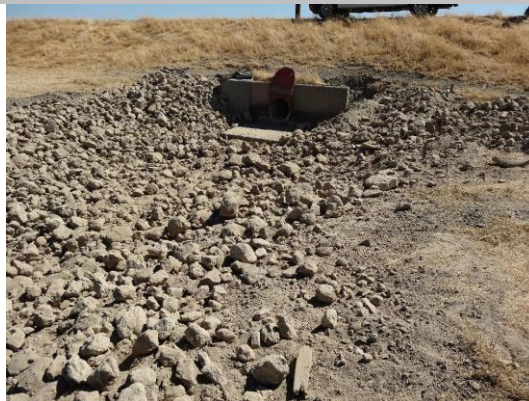
Photo 2 of 3 : UCIP\_SP\_2018\_51312\_75488.jpg

WS drainage path protected by rip rap.

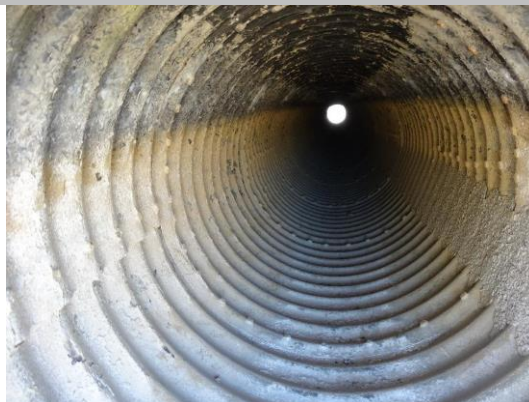
Photo 3 of 3 : UCIP\_SP\_2018\_51312\_75489.jpg

Inside view of pipe from WS.

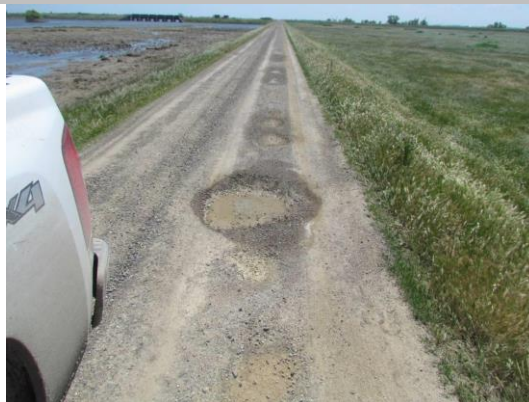
Photo 1 of 2 : SP\_2018\_NA0010\_124\_6\_20180307\_00010.jpg

LM Start	6.44	Rating **	M	Issue No.	6
LM End	11.00	Issue Type +	Ma	Location *	CR
Category	Earthen Levee			GPS Latitude/Longitude	
				Start	End
Item	Crown Surface / Depressions / Rutting			37.233587 °	37.187645 °
				-120.732480 °	-120.676996 °
DWR ID	DWR_NA0010_06_s _ 2012_6				
Comment Code					
C2 : Repair depressions or ruts in the crown or slope.					
Inspector Comment					
Levee crown should be regraded due to excessive rutting and potholes on levee crown..

Looking upstream at large pot hole on levee crown.

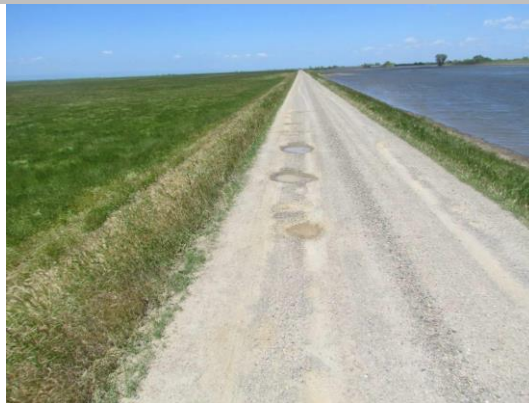
Photo 2 of 2 : SP\_2018\_NA0010\_124\_6\_20180307\_00011.jpg

LM Start	6.44	Rating **	M	Issue No.	6 (cont)	
LM End	11.00	Issue Type +	Ma	Location *	CR	
Category	Earthen Levee			GPS Latitude/Longitude		
				Start		End
Item	Crown Surface / Depressions / Rutting			37.233587 °		37.187645 °
				-120.732480 °		-120.676996 °
DWR ID	DWR_NA0010_06_s_2012_6					
Comment Code						
C2 : Repair depressions or ruts in the crown or slope.						
Inspector Comment						
Levee crown should be regraded due to excessive rutting and potholes on levee crown..

Looking downstream at typical view of rutting and pot holes on levee crown.

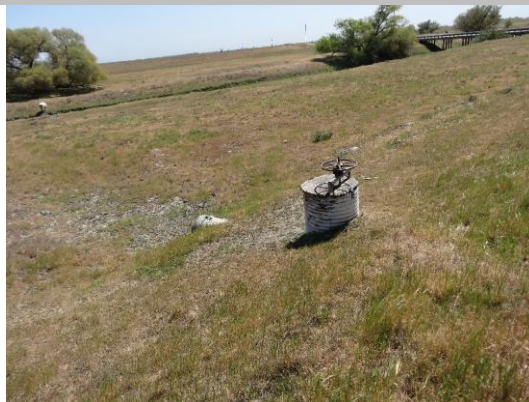
Photo 1 of 3 : UCIP\_SP\_2018\_33984\_61628.jpg

Slide gate inside CMP riser and pipe visible on waterward side.

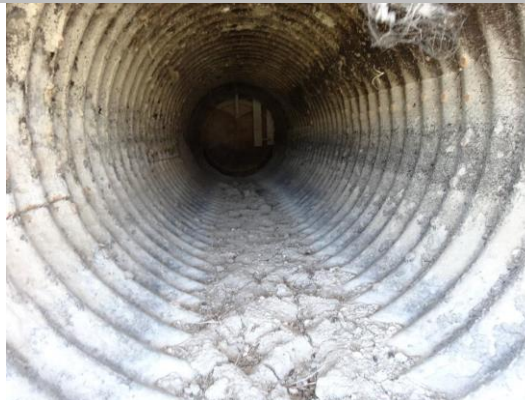
Photo 3 of 3 : UCIP\_SP\_2018\_33984\_61626.jpg

Inside view pipe from waterward side.

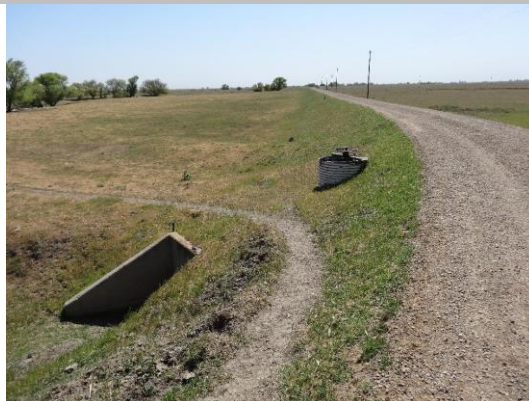
Photo 1 of 3 : UCIP\_SP\_2018\_33985\_61640.jpg

View of waterward side.

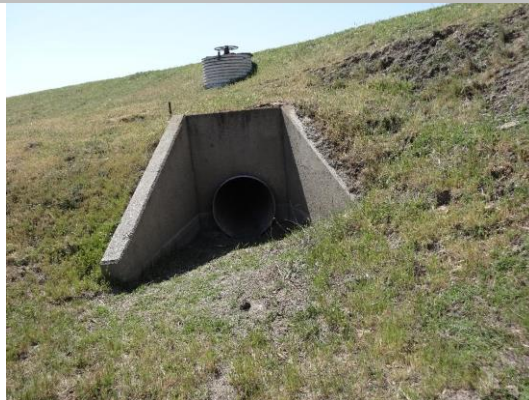
Photo 2 of 3 : UCIP\_SP\_2018\_33985\_61639.jpg

Concrete headwall and CMP riser visible on waterward side.

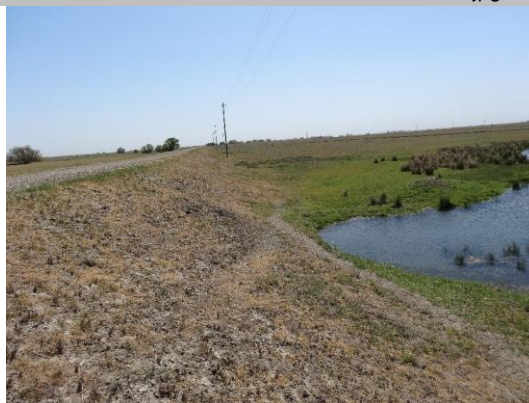
Photo 3 of 3 : UCIP\_SP\_2018\_33985\_61638.jpg

View of landward side.

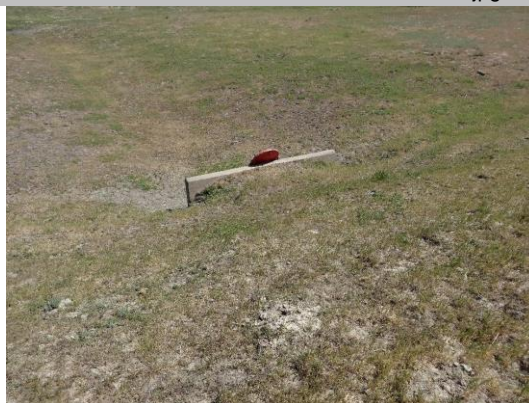
Photo 1 of 3 : UCIP\_SP\_2018\_39471\_61650.jpg

View of waterward side.

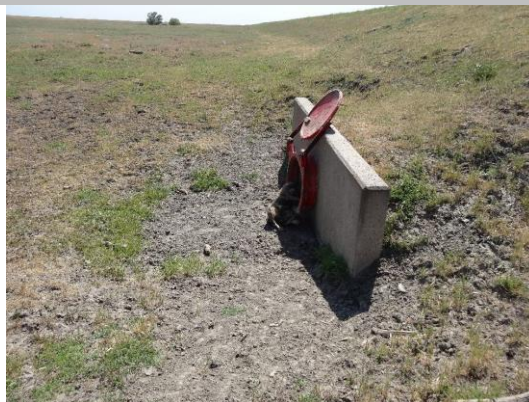
Photo 2 of 3 : UCIP\_SP\_2018\_39471\_61649.jpg

Concrete headwall and flap gate visible on waterward side. Dead animal inside pipe.

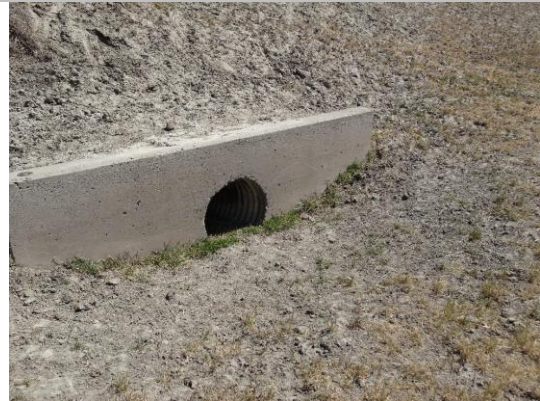
Photo 3 of 3 : UCIP\_SP\_2018\_39471\_61648.jpg

View of landward side.

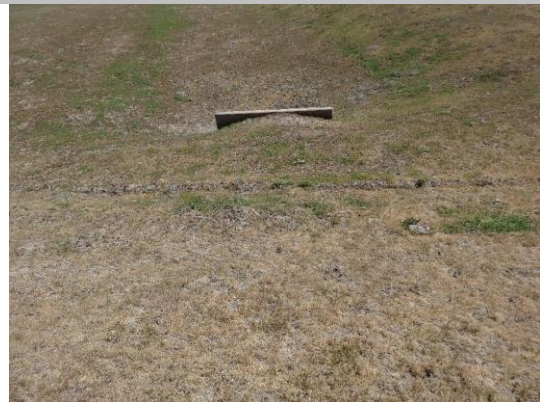
Photo 1 of 3 : UCIP\_SP\_2018\_39472\_66462.jpg

View of waterward side.

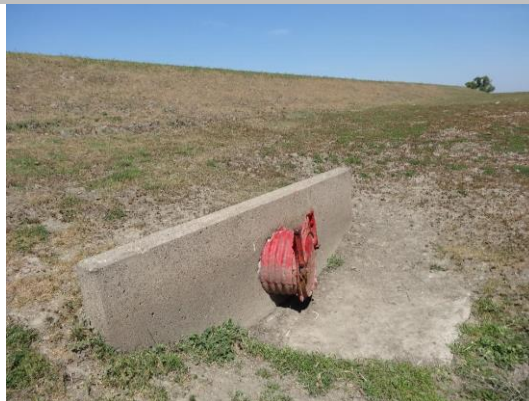
Photo 2 of 3 : UCIP\_SP\_2018\_39472\_66461.jpg

Pipe crosses levee at an angle.

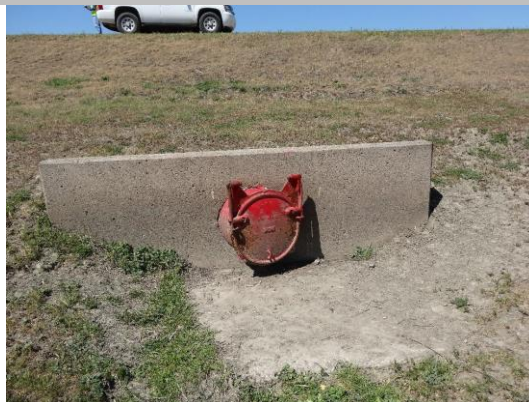
Photo 3 of 3 : UCIP\_SP\_2018\_39472\_66460.jpg

Concrete headwall and flap gate visible on waterward side.

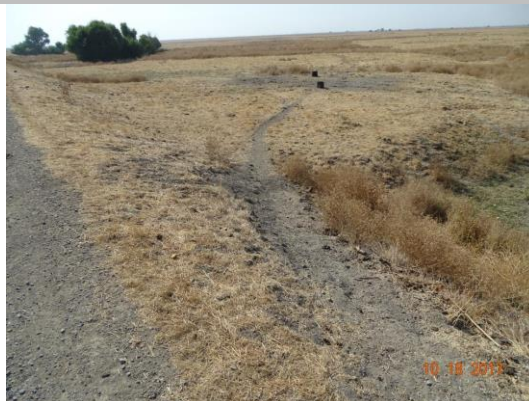
Photo 1 of 1 : SP\_2018\_NA0010\_124\_65\_20180307\_00015.jpg

LM Start	8.08	Rating **	M	Issue No.	65
LM End	8.08	Issue Type +	Ma	Location *	LS
Category	Earthen Levee			GPS Latitude/Longitude	
				Start	End
Item	Slope Stability			37.217199 °	37.217199 °
				-120.713374 °	-120.713374 °
DWR ID	DWR_NA0010_06_f_2017_65				
Comment Code					
S2 : Repair the levee slope damaged by foot traffic and prevent access where possible.					
Inspector Comment

Looking southwest at the landside slope.

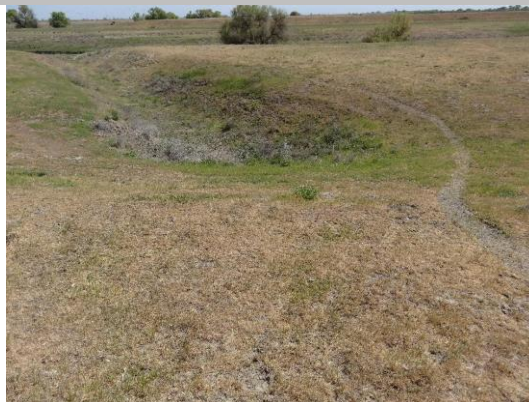
Photo 1 of 3 : UCIP\_SP\_2018\_39473\_61674.jpg

View of waterward side.

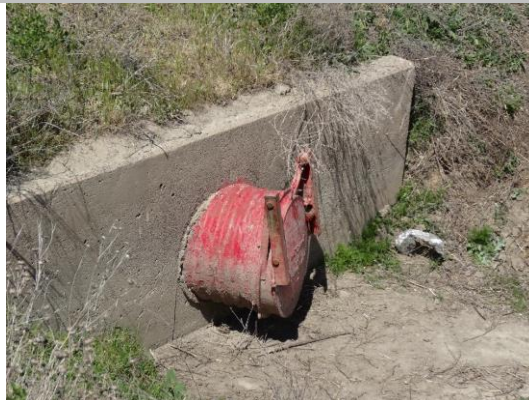
Photo 3 of 3 : UCIP\_SP\_2018\_39473\_61672.jpg

Concrete headwall and flap gate visible on waterward side.

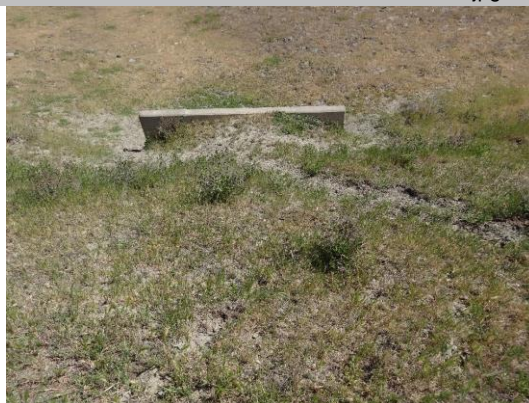
Photo 1 of 3 : UCIP\_SP\_2018\_39474\_61685.jpg

Comment Code					
Inspector Comment					
FS_ID:39474 DS_ID:19871 EP_NO: N/A Repair Type: Non-Urgent Crossing Status: Found UCIP Comments: Need to contact owner. Sediment buildup in pipe visible on landward side--recommend clearing. Good candidate for pressure test or video inspection due to signs of heavy corrosion. If no leaks after tests this crossing would be a good candidate for rehabilitation. FIELD_STRUCT_DESC: 24-inch corrugated metal gravity drainage pipe through the levee, 9.2 feet below the crown. Flap gate on the waterside (WS) end. Concrete headwall on each end. [Additional Reference(s): DWR Levee Log, 2002. USACE San Joaquin O&M Manual 601.1, 1967, (HLM 8.51)]. FS Date: 4/18/2014

View of waterward side.

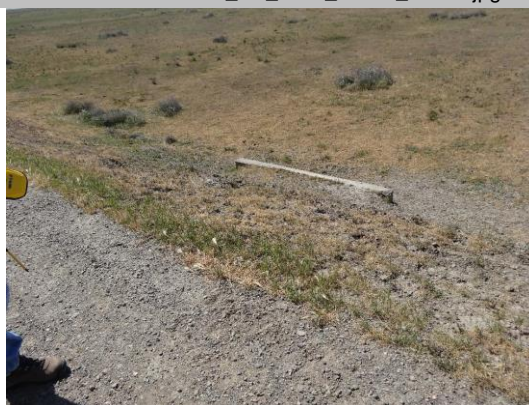
Photo 2 of 3 : UCIP\_SP\_2018\_39474\_61684.jpg

View of landward side.

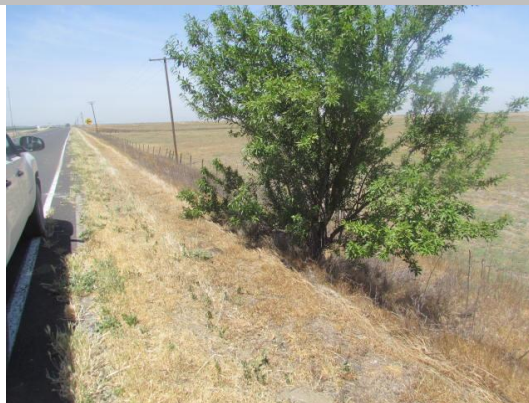
Photo 1 of 1 : SP\_2018\_NA0010\_124\_14\_20180307\_00014.jpg

LM Start	11.49	Rating **	M	Issue No.	14
LM End	11.49	Issue Type +	Ma	Location *	WS
Category	Earthen Levee			GPS Latitude/Longitude	
				Start	End
Item	Trim / Thin Trees			37.186189 °	37.186189 °
				-120.668476 °	-120.668476 °
DWR ID	DWR_NA0010_06_s_2015_14				
Comment Code					
T1 : Trim trees to at least five feet above ground level.					
Inspector Comment					
Almond tree located along Sandy Mush Rd. on waterside slope.

Looking west at tree on waterward slope.
