**Flood Control Project Maintenance  
Levee Inspections**

## Maintenance Issue Types Only, Levee Inspection Report By Mile - Spring 2018

### Lower San Joaquin Levee District

Waterway	Bank	Unit Miles	Inspection Start/End	Inspector
Unit No. 01 San Joaquin River	Right	22.52	04/04/2018 04/16/2018	Richard Willoughby

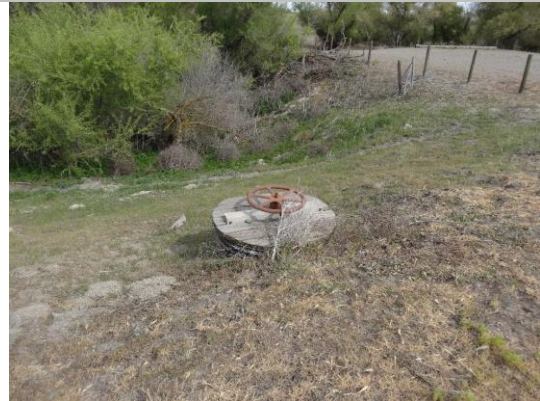
Photo 3 of 3 : UCIP\_SP\_2018\_39476\_66486.jpg

LM Start	11.74	Rating **	M	Issue No.	1249 (cont)	
LM End	11.74	Issue Type +	Ma	Location *		
Category	Supplemental			GPS Latitude/Longitude		
				Start		End
Item	DWR UCIP LMA Responsibility			37.185513 °		37.185513 °
				-120.664561 °		-120.664561 °
DWR ID						
Comment Code						
Inspector Comment						
FS_ID:39476 DS_ID:19876 EP_NO: N/A Repair Type: Non-Urgent Crossing Status: Found UCIP Comments: Clear debris from waterward and landward toes. FIELD_STRUCT_DESC: 36-inch corrugated metal gravity drainage pipe through the levee, 17 feet below the crown. Slide gate in a pipe riser on the waterside (WS) slope. [Additional Reference(s): DWR Levee Log, 2002. USACE San Joaquin O&M Manual 601.1, 1967, (HLM 11.82)]. FS Date: 4/17/2014

Slide gate inside CMP riser located on waterward slope.

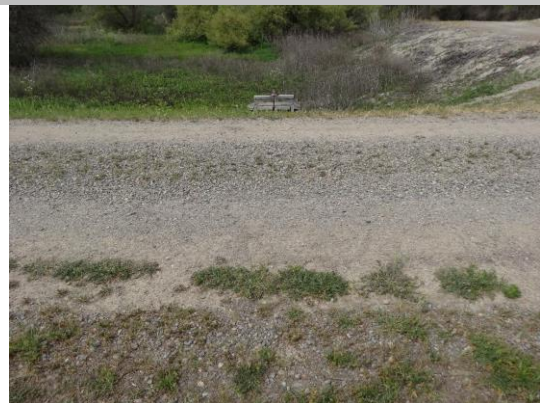
Photo 1 of 3 : UCIP\_SP\_2018\_39477\_66492.jpg

LM Start	13.22	Rating **	M	Issue No.	1250
LM End	13.22	Issue Type +	Ma	Location *	
Category	Supplemental			GPS Latitude/Longitude	
				Start	End
Item	DWR UCIP LMA Responsibility			37.171675 °	37.171675 °
				-120.655064 °	-120.655064 °
DWR ID					
Comment Code					
Inspector Comment					
FS_ID:39477					
DS_ID:19877					
EP_NO: N/A					
Repair Type: Non-Urgent					
Crossing Status: Found					
UCIP Comments: Not accessible--crossing is buried on landward side.					
Need to contact owner to determine status.					
FIELD_STRUCT_DESC: 24-inch corrugated metal gravity drainage pipe					
through the levee, 10.8 feet below the crown. Flap gate on the					
waterside (WS) end. [Additional Reference(s): DWR Levee Log, 2002.					
USACE San Joaquin O&M Manual 601.1, 1967, (HLM 13.30)].					
FS Date: 4/17/2014

View of levee crown at crossing.

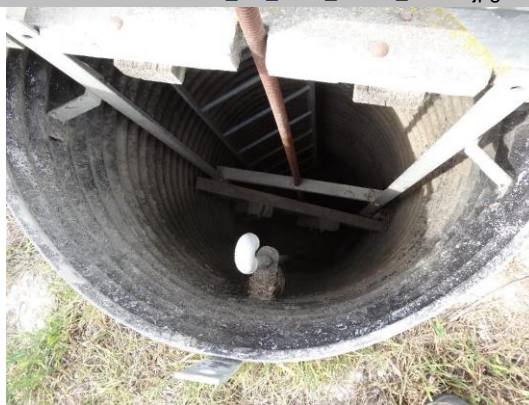
Photo 3 of 3 : UCIP\_SP\_2018\_39477\_66495.jpg

Inside view of CMP riser located on waterward slope.

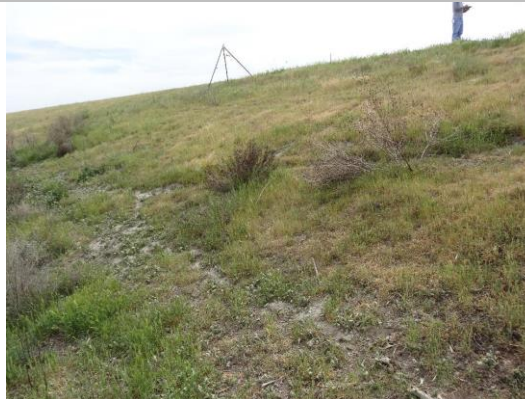
Photo 1 of 3 : UCIP\_SP\_2018\_39478\_66496.jpg

LM Start	14.36	Rating **	M	Issue No.	1251
LM End	14.36	Issue Type +	Ma	Location *	
Category	Supplemental			GPS Latitude/Longitude	
				Start	End
Item	DWR UCIP LMA Responsibility			37.167888 °	37.167888 °
				-120.636419 °	-120.636419 °
DWR ID					
Comment Code					
Inspector Comment					
FS_ID:39478 DS_ID:19878 EP_NO: N/A Repair Type: Non-Urgent Crossing Status: Found UCIP Comments: Not accessible--crossing is buried on landward side. Need to contact owner to determine status. FIELD_STRUCT_DESC: 24-inch corrugated metal gravity drainage pipe through the levee, 12.3 feet below the crown. Flap gate on the waterside (WS) end. [Additional Reference(s): DWR Levee Log, 2002. USACE San Joaquin O&M Manual 601.1, 1967, (HLM 14.44)]. FS Date: 4/17/2014

View of waterward slope.

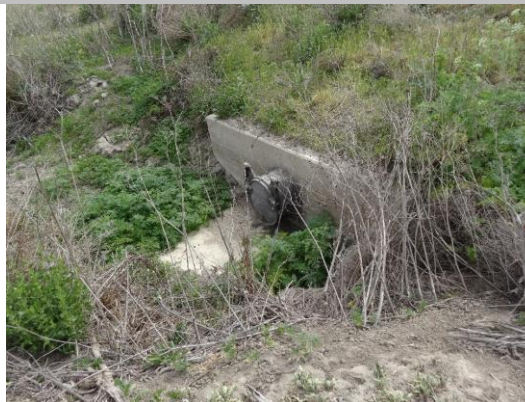
Photo 2 of 3 : UCIP\_SP\_2018\_39478\_66497.jpg

View of pipe daylight, flap gate, and concrete headwall visible on waterward toe.

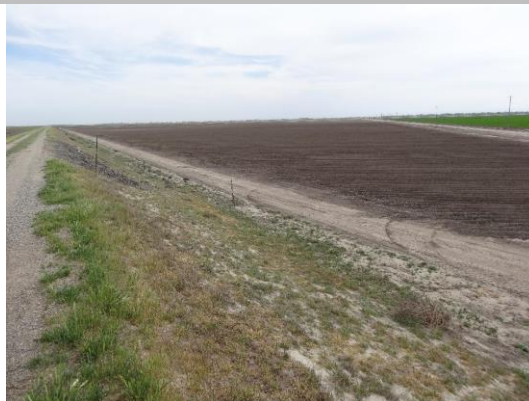
Photo 3 of 3 : UCIP\_SP\_2018\_39478\_66498.jpg

LM Start	14.36	Rating **	M	Issue No.	1251 (cont)
LM End	14.36	Issue Type +	Ma	Location *	
Category	Supplemental			GPS Latitude/Longitude	
				Start	End
Item	DWR UCIP LMA Responsibility			37.167888 °	37.167888 °
				-120.636419 °	-120.636419 °
DWR ID					
Comment Code					
Inspector Comment					
FS_ID:39478 DS_ID:19878 EP_NO: N/A Repair Type: Non-Urgent Crossing Status: Found UCIP Comments: Not accessible--crossing is buried on landward side. Need to contact owner to determine status. FIELD_STRUCT_DESC: 24-inch corrugated metal gravity drainage pipe through the levee, 12.3 feet below the crown. Flap gate on the waterside (WS) end. [Additional Reference(s): DWR Levee Log, 2002. USACE San Joaquin O&M Manual 601.1, 1967, (HLM 14.44)]. FS Date: 4/17/2014

View of landward slope.

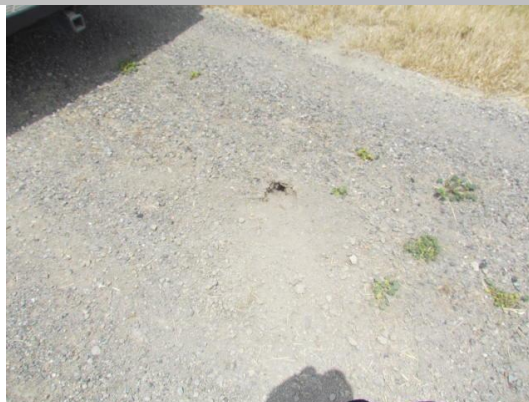
Photo 1 of 1 : SP\_2018\_NA0010\_124\_1212\_20180307\_00046.jpg

LM Start	14.94	Rating **	M	Issue No.	1212
LM End	14.94	Issue Type +	Ma	Location *	CR
Category	Earthen Levee			GPS Latitude/Longitude	
				Start	End
Item	Animal Control			37.162287 °	37.162287 °
				-120.628791 °	-120.628791 °
DWR ID	DWR_NA0010_06_s _ 2015_1212				
Comment Code					
A3 : No rodents visible, but rodent burrows visible; need to backfill and compact or grout burrows.					
Inspector Comment					
Several rodent holes noted on levee crown and landside and waterside slopes.

Looking at rodent hole on levee crown.

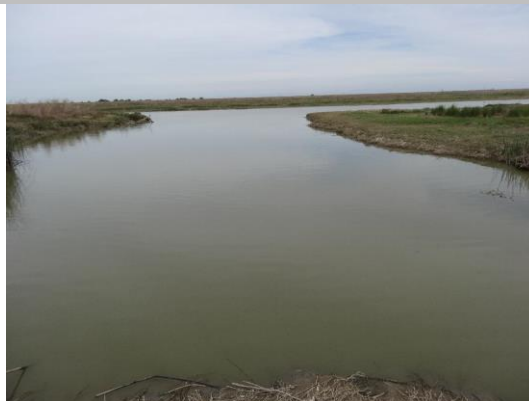
Photo 3 of 3 : UCIP\_SP\_2018\_36663\_66529.jpg

Item	DWR UCIP LMA Responsibility			37.155539 °	37.155539 °	
				-120.615303 °	-120.615303 °	
DWR ID						
Comment Code						
Inspector Comment						
FS_ID:36663 DS_ID:19885 EP_NO: N/A Repair Type: Non-Urgent Crossing Status: Found UCIP Comments: Need to contact owner to determine status of crossing. Waterward side is buried and not accessible. Landward side headwall is blocked by dense vegetation. Recommend confirming status of flap gate on waterward side and removing dense vegetation form landward side. FIELD_STRUCT_DESC: 36-inch corrugated metal gravity drainage pipe through the levee, 16.6 feet below the crown. Flap gate on the waterside (WS) end. [Additional Reference(s): DWR Levee Log, 2002. USACE San Joaquin O&M Manual 601.1, 1967, (HLM 15.91)]. FS Date: 4/17/2014

View of waterward side, photo 3 of 3.

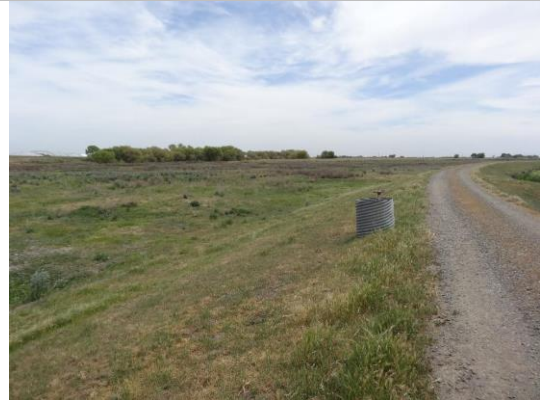
Photo 1 of 3 : UCIP\_SP\_2018\_36687\_66579.jpg

Comment Code						
Inspector Comment						
FS_ID:36687						
DS_ID:19889						
EP_NO: N/A						
Repair Type: Non-Urgent						
Crossing Status: Found						
UCIP Comments: Dense vegetation limits the inspector's visibility to identify signs of pipe failure (leaks) along the landward slope.						
Recommend removing vegetation along pipe alignment to conduct proper inspection of structure.						
FIELD_STRUCT_DESC: 24-inch corrugated metal gravity drainage pipe through the levee, 10.2 feet below the crown. Slide gate in a pipe riser on the waterside (WS) slope. [Additional Reference(s): DWR Levee Log, 2002. USACE San Joaquin O&M Manual 601.1, 1967, (HLM 18.97)].						
FS Date: 4/17/2014

View of waterward side.

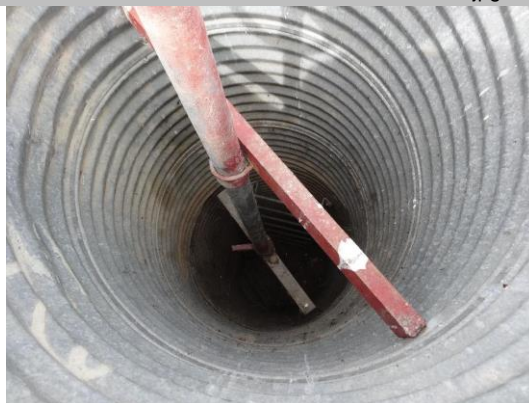
Photo 2 of 3 : UCIP\_SP\_2018\_36687\_66582.jpg

Inside view of CMP riser located on waterward slope.

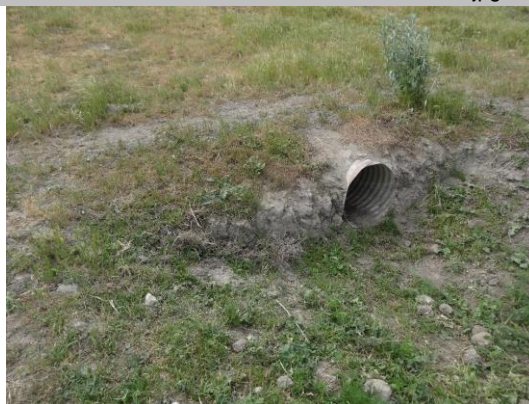
Photo 3 of 3 : UCIP\_SP\_2018\_36687\_66581.jpg

Pipe daylight on waterward side.

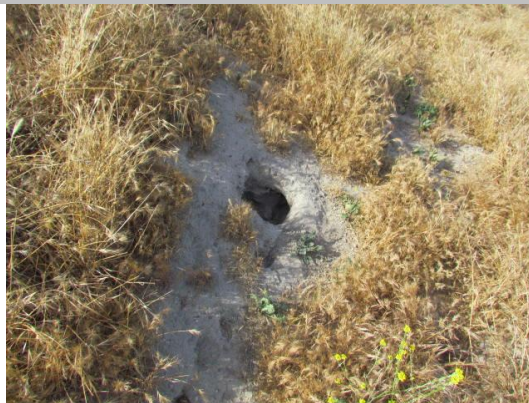
Photo 1 of 5 : SP\_2018\_NA0010\_124\_1211\_20180307\_00041.jpg

LM Start	19.14	Rating **	U	Issue No.	1211
LM End	19.14	Issue Type +	Ma	Location *	WS
Category	Earthen Levee			GPS Latitude/Longitude	
				Start	End
Item	Animal Control			37.114793 °	37.114793 °
				-120.587582 °	-120.587582 °
DWR ID	DWR_NA0010_06_s_2015_1211				
Comment Code					
A1 : Exterminate rodents and backfill and compact or grout burrows.					
Inspector Comment					
Several large rodent holes with more than 2 cubic feet of material were noted on the waterside slope.

Looking at rodent hole on waterward slope. Spring 2016

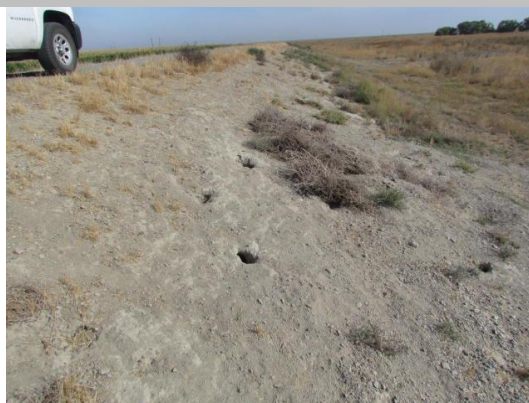
Photo 2 of 5 : SP\_2018\_NA0010\_124\_1211\_20180307\_00042.jpg

Looking at several rodent holes on waterward slope. (Fall 2015)

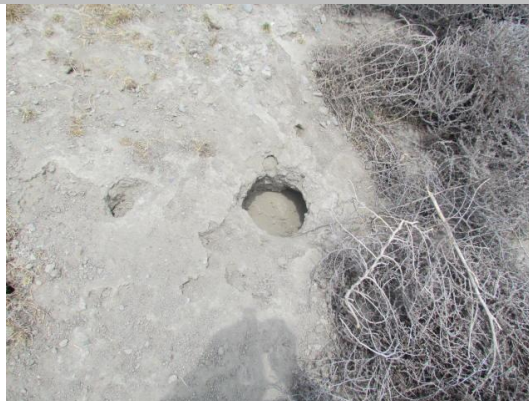
Photo 4 of 5 : SP\_2018\_NA0010\_124\_1211\_20180307\_00044.jpg

LM Start	19.14	Rating **	U	Issue No.	1211 (cont)
LM End	19.14	Issue Type +	Ma	Location *	WS
Category	Earthen Levee			GPS Latitude/Longitude	
				Start	End
Item	Animal Control			37.114793 °	37.114793 °
				-120.587582 °	-120.587582 °
DWR ID	DWR_NA0010_06_s_2015_1211				
Comment Code					
A1 : Exterminate rodents and backfill and compact or grout burrows.					
Inspector Comment					
Several large rodent holes with more than 2 cubic feet of material were noted on the waterside slope.

Looking at large rodent hole on waterward slope. Spring 2015

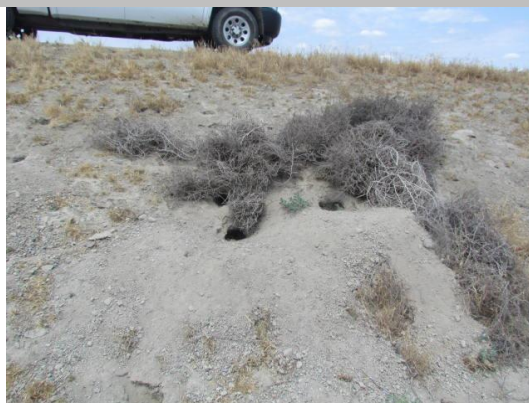
Photo 5 of 5 : SP\_2018\_NA0010\_124\_1211\_20180307\_00045.jpg

Looking west at several rodent holes on waterward slope. Spring 2015

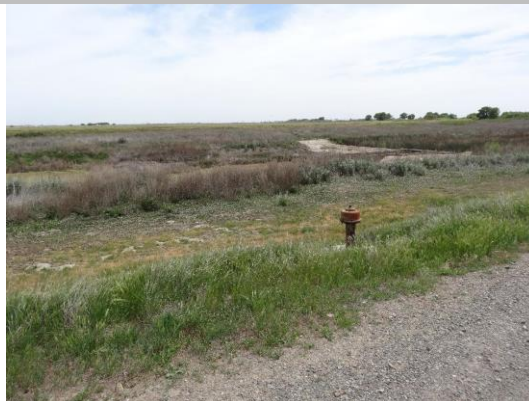
Photo 1 of 3 : UCIP\_SP\_2018\_36688\_66583.jpg

Comment Code						
Inspector Comment						
FS_ID:36688 DS_ID:19890 EP_NO: N/A Repair Type: Non-Urgent Crossing Status: Found UCIP Comments: Dense vegetation limits the inspector's visibility to identify signs of pipe failure (leaks) along the slopes. Recommend removing vegetation along pipe alignment to conduct proper inspection of structure. FIELD_STRUCT_DESC: 48-inch corrugated metal gravity drainage pipe through the levee, 20 feet below the crown. Slide gate in a pipe riser on the waterside (WS) slope. Riprap along the landside (LS) slope. [Additional Reference(s): DWR Levee Log, 2002. USACE San Joaquin O&M Manual 601.1, 1967, (HLM 19.36)]. FS Date: 4/17/2014

View of waterward side.

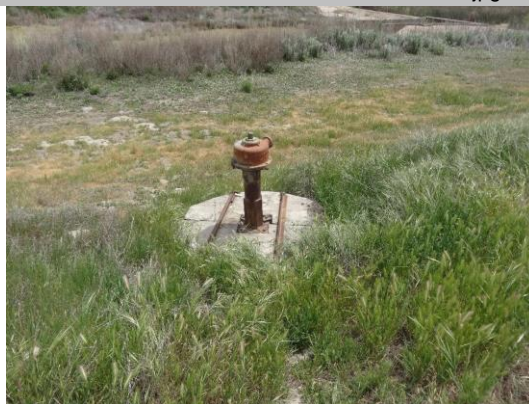
Photo 2 of 3 : UCIP\_SP\_2018\_36688\_66584.jpg

Riser located on waterward slope.

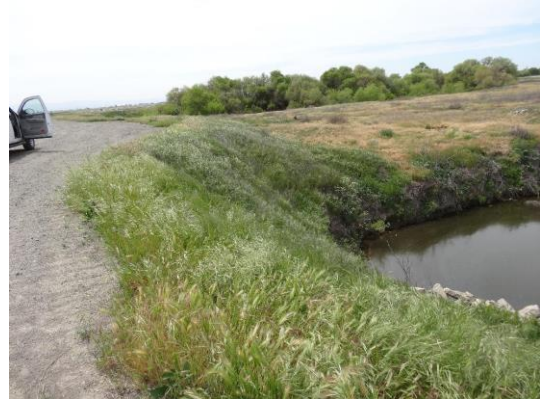
Photo 3 of 3 : UCIP\_SP\_2018\_36688\_66586.jpg

Item	DWR UCIP LMA Responsibility			37.112902 °	37.112902 °	
				-120.588751 °	-120.588751 °	
DWR ID						
Comment Code						
Inspector Comment						
FS_ID:36688 DS_ID:19890 EP_NO: N/A Repair Type: Non-Urgent Crossing Status: Found UCIP Comments: Dense vegetation limits the inspector's visibility to identify signs of pipe failure (leaks) along the slopes. Recommend removing vegetation along pipe alignment to conduct proper inspection of structure. FIELD_STRUCT_DESC: 48-inch corrugated metal gravity drainage pipe through the levee, 20 feet below the crown. Slide gate in a pipe riser on the waterside (WS) slope. Riprap along the landside (LS) slope. [Additional Reference(s): DWR Levee Log, 2002. USACE San Joaquin O&M Manual 601.1, 1967, (HLM 19.36)]. FS Date: 4/17/2014

View of landward slope.

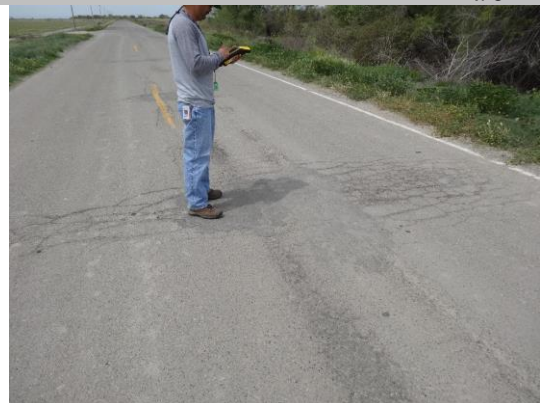
Photo 1 of 3 : UCIP\_SP\_2018\_36689\_66591.jpg

Comment Code						
Inspector Comment						
FS_ID:36689						
DS_ID:19891						
EP_NO: N/A						
Repair Type: Non-Urgent						
Crossing Status: Found						
UCIP Comments: Dense vegetation limits the inspector's visibility to identify signs of pipe failure (leaks) along the slopes. Recommend removing vegetation along pipe alignment to conduct proper inspection of structure.						
FIELD_STRUCT_DESC: 30-inch by 30-inch reinforced concrete box gravity drainage culvert through the levee, 14 feet below the crown. Flap gate on the waterside (WS) end. [Additional Reference(s): DWR Levee Log, 2002. USACE San Joaquin O&M Manual 601.1, 1967, (HLM 19.85)].						
FS Date: 4/17/2014

Overview of levee crown looking downstream.

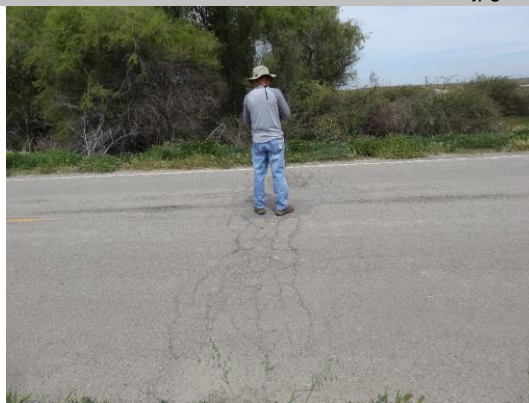
Photo 2 of 3 : UCIP\_SP\_2018\_36689\_66592.jpg

FS\_ID:36689  
DS\_ID:19891  
EP\_NO: N/A  
Repair Type: Non-Urgent  
Crossing Status: Found  
UCIP Comments: Dense vegetation limits the inspector's visibility to identify signs of pipe failure (leaks) along the slopes. Recommend removing vegetation along pipe alignment to conduct proper inspection of structure.  
FIELD\_STRUCT\_DESC: 30-inch by 30-inch reinforced concrete box gravity drainage culvert through the levee, 14 feet below the crown. Flap gate on the waterside (WS) end. [Additional Reference(s): DWR Levee Log, 2002. USACE San Joaquin O&M Manual 601.1, 1967, (HLM 19.85)].  
FS Date: 4/17/2014

View of levee crown at crossing.

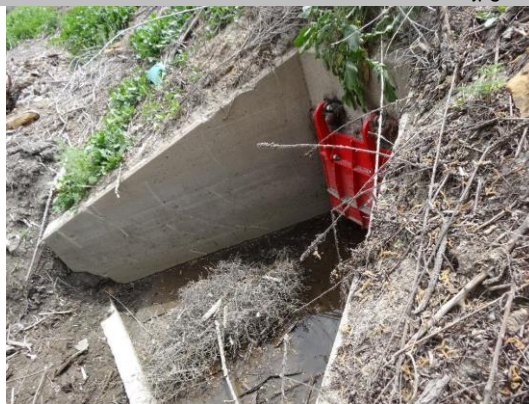
Photo 3 of 3 : UCIP\_SP\_2018\_36689\_66590.jpg

View of "U" concrete headwall located on waterward side.

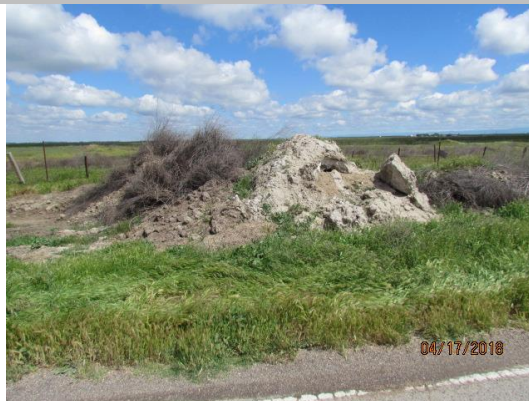
Photo 1 of 1 : SP\_2018\_NA0010\_124\_71\_20180420\_00184.jpg

LM Start	20.05	Rating **	M	Issue No.	71
LM End	20.05	Issue Type +	Ma	Location *	WS
Category	Earthen Levee			GPS Latitude/Longitude	
				Start	End
Item	Encroachments			37.113256 °	37.113256 °
				-120.577092 °	-120.577092 °
DWR ID	DWR_NA0010_06_s_2018_71				
Comment Code					
MA : Material					
Inspector Comment					
Material stock pile on waterward shoulder.

Looking east at material stockpile on waterward shoulder. (Spring 2018)

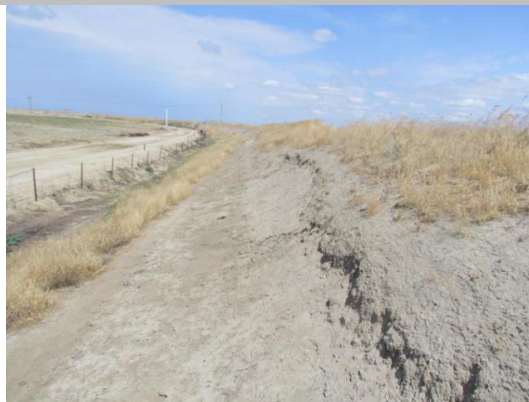
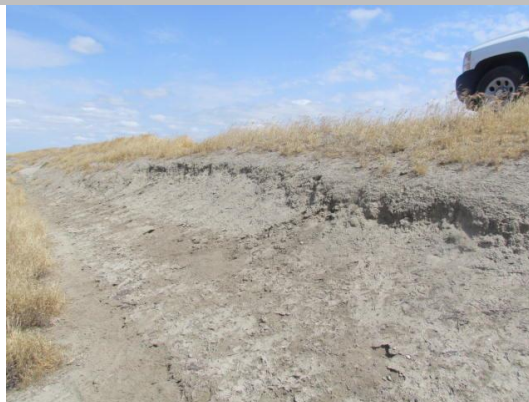
LM Start	20.79	Rating **	M	Issue No.	1209
LM End	20.88	Issue Type +	Ma	Location *	LS
Category	Earthen Levee			GPS Latitude/Longitude	
				Start	End
Item	Erosion / Bank Caving			37.113107 °	37.112176 °
				-120.563782 °	-120.562516 °
DWR ID	DWR_NA0010_06_s_2015_1209				
Comment Code					
E1 : Note and monitor erosion site.					
Inspector Comment					
Erosion on landside slope greater than 3 inches. Erosion caused by livestock.

Looking north at livestock erosion on landward slope.

Looking northeast at livestock erosion on landward slope.

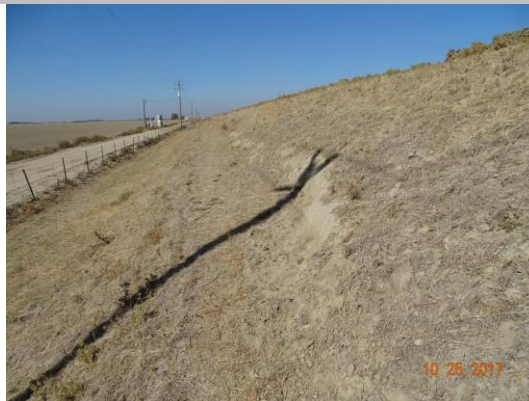
Photo 1 of 1 : SP\_2018\_NA0010\_124\_86\_20180307\_00035.jpg

LM Start	22.41	Rating **	M	Issue No.	86
LM End	22.46	Issue Type +	Ma	Location *	LS
Category	Earthen Levee			GPS Latitude/Longitude	
				Start	End
Item	Slope Stability			37.094969 °	37.094479 °
				-120.544964 °	-120.544435 °
DWR ID	DWR_NA0010_06_f_2017_86				
Comment Code					
S2 : Repair the levee slope damaged by foot traffic and prevent access where possible.					
Inspector Comment					
Erosion greater than 3 inches on landside slope caused by livestock.

Looking northwest at the landside slope.

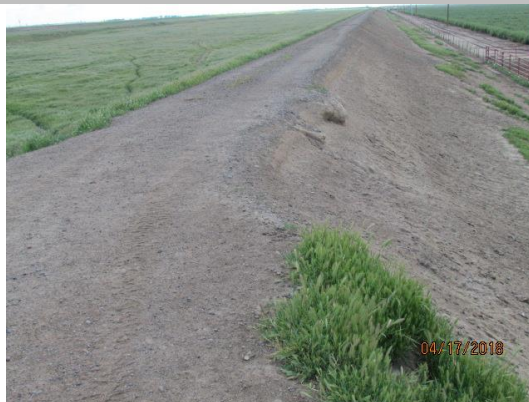
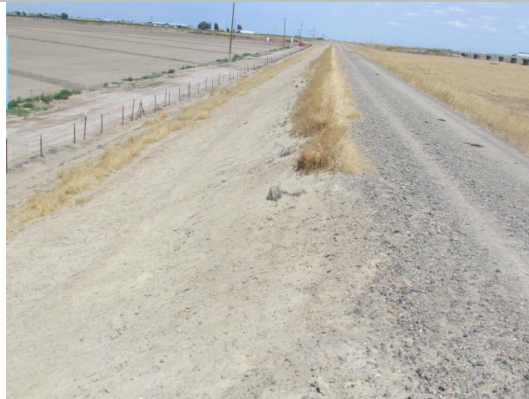
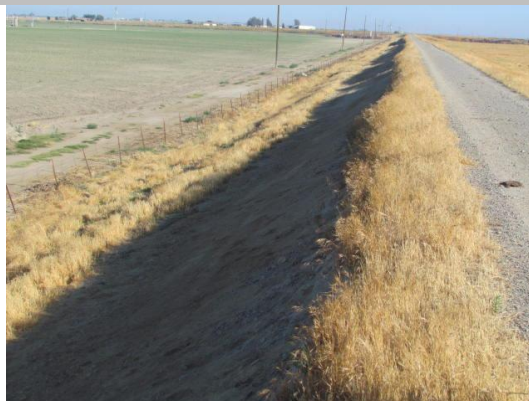
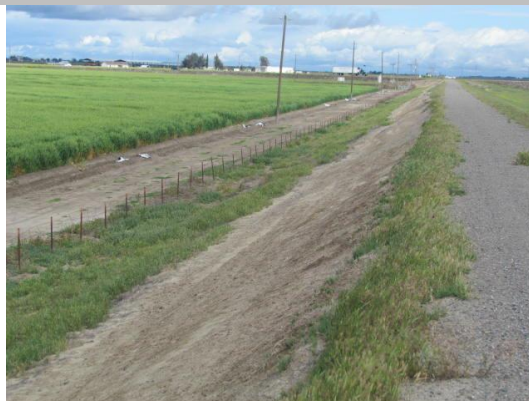
LM Start	24.58	Rating **	M	Issue No.	5	
LM End	24.93	Issue Type +	Ma	Location *	LS	
Category	Earthen Levee			GPS Latitude/Longitude		
				Start		End
Item	Slope Stability			37.071198 °		°
				-120.519220 °		°
DWR ID	DWR_NA0010_06_s_2012_5					
Comment Code						
S2 : Repair the levee slope damaged by foot traffic and prevent access where possible.						
Inspector Comment						
Landside erosion caused by livestock extends into landward shoulder.

Looking north at livestock erosion into landward shoulder. (Spring 2018)

Looking north at livestock erosion on landward slope. (Spring 2015)

Looking north at livestock erosion on landward slope. (Spring 2014)

Looking north at livestock erosion on landside slope. (Fall 2014)

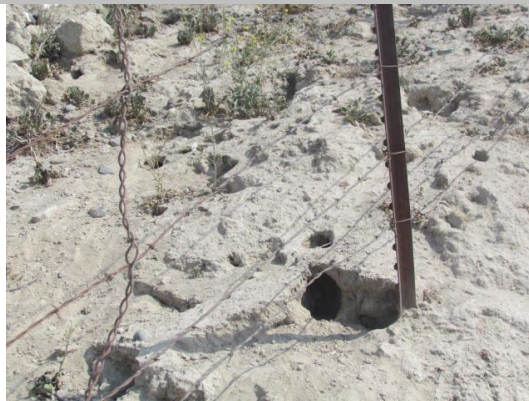
Photo 1 of 1 : SP\_2018\_NA0010\_124\_1208\_20180307\_00038.jpg

LM Start	26.13	Rating **	M	Issue No.	1208
LM End	26.13	Issue Type +	Ma	Location *	LS
Category	Earthen Levee			GPS Latitude/Longitude	
				Start	End
Item	Animal Control			37.054222 °	37.054222 °
				-120.500862 °	-120.500862 °
DWR ID	DWR_NA0010_06_s _ 2015_1208				
Comment Code					
A1 : Exterminate rodents and backfill and compact or grout burrows.					
Inspector Comment					
Noted several rodent holes next to and within rock revetment on landside slope.

Rodent holes on landward slope.

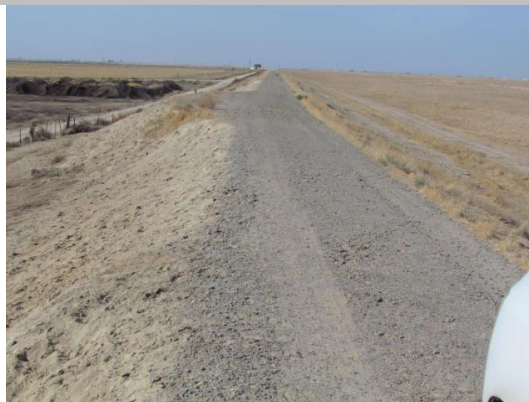
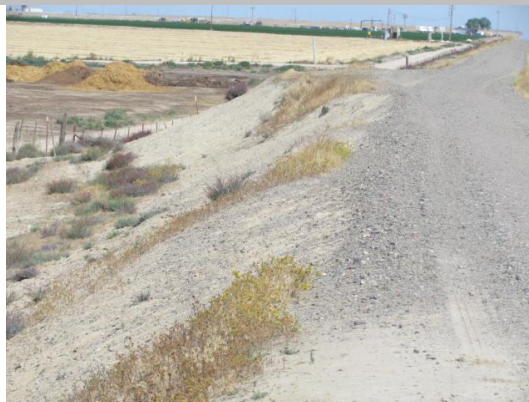
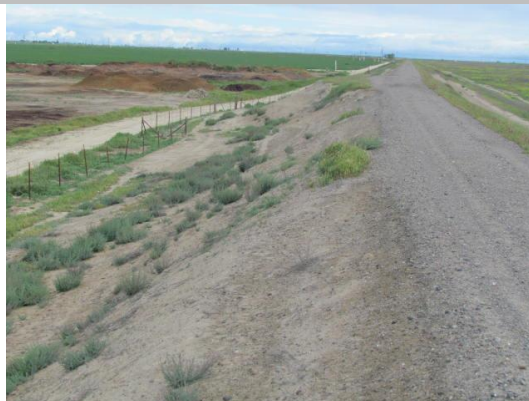
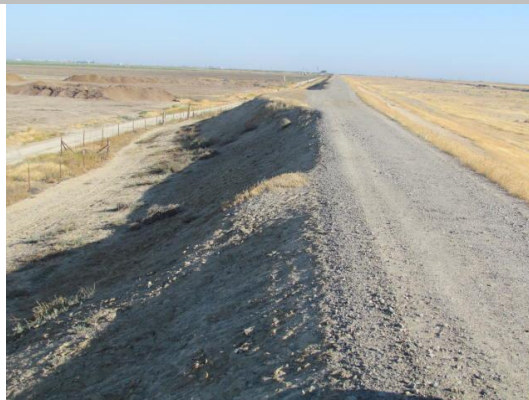
LM Start	27.64	Rating **	M	Issue No.	3
LM End	27.97	Issue Type +	Ma	Location *	LS
Category	Earthen Levee			GPS Latitude/Longitude	
				Start	End
Item	Slope Stability			37.036955 °	37.032887 °
				-120.484395 °	-120.481225 °
DWR ID	DWR_NA0010_06_s _ 2012_3				
Comment Code					
S2 : Repair the levee slope damaged by foot traffic and prevent access where possible.					
Inspector Comment					
Landside erosion caused by livestock. Erosion greater than 3" in depth on landside slope. Levee crown has narrowed within this reach.

Looking north at livestock erosion on landward slope. Fall 2015

Looking north at livestock erosion on landward shoulder and slope.(Spring 2015)

Looking north at livestock erosion on landside shoulder and slope. (Fall 2014)

Looking north at livestock erosion on landward slope. (Spring 2013)

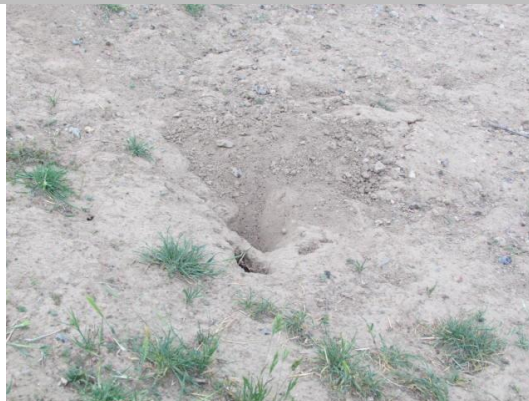
Photo 2 of 2 : SP\_2018\_NA0010\_124\_2\_20180307\_00002.jpg

LM Start	31.10	Rating **	U	Issue No.	2 (cont)	
LM End	31.10	Issue Type +	Ma	Location *	LS	
Category	Earthen Levee			GPS Latitude/Longitude		
				Start		End
Item	Animal Control			37.017955 °		37.017955 °
				-120.435017 °		-120.435017 °
DWR ID	DWR_NA0010_06_s_2012_2					
Comment Code						
A1 : Exterminate rodents and backfill and compact or grout burrows.						
Inspector Comment

Looking at typical rodent hole on landside slope.

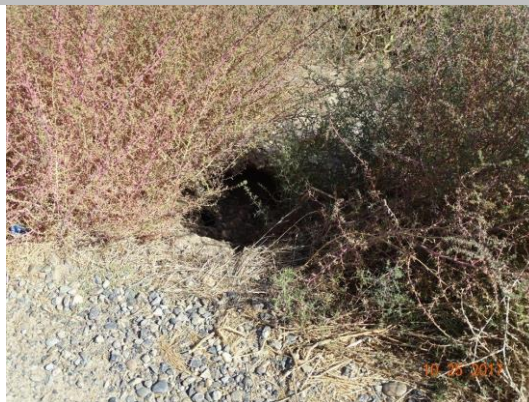
Photo 1 of 1 : SP\_2018\_NA0010\_124\_82\_20180307\_00033.jpg

LM Start	31.14	Rating **	U	Issue No.	82
LM End	31.14	Issue Type +	Ma	Location *	WS
Category	Earthen Levee			GPS Latitude/Longitude	
				Start	End
Item	Animal Control			37.017445 °	37.017445 °
				-120.434713 °	-120.434713 °
DWR ID	DWR_NA0010_06_f_2017_82				
Comment Code					
A3 : No rodents visible, but rodent burrows visible; need to backfill and compact or grout burrows.					
Inspector Comment

Looking east at the waterside slope.

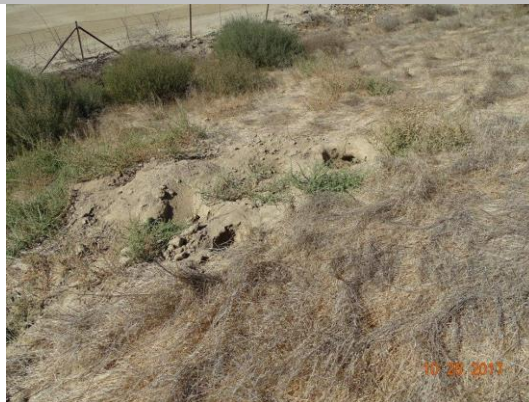
Photo 1 of 1 : SP\_2018\_NA0010\_124\_81\_20180307\_00032.jpg

LM Start	32.00	Rating **	U	Issue No.	81
LM End	32.00	Issue Type +	Ma	Location *	LS
Category	Earthen Levee			GPS Latitude/Longitude	
				Start	End
Item	Animal Control			37.007007 °	37.007007 °
				-120.426179 °	-120.426179 °
DWR ID	DWR_NA0010_06_f_2017_81				
Comment Code					
A3 : No rodents visible, but rodent burrows visible; need to backfill and compact or grout burrows.					
Inspector Comment

Looking west at the landside slope.

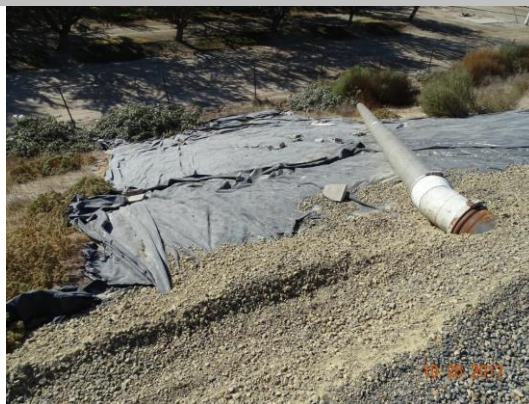
Photo 1 of 1 : SP\_2018\_NA0010\_124\_77\_20180307\_00029.jpg

LM Start	35.85	Rating **	M	Issue No.	77
LM End	35.85	Issue Type +	Ma	Location *	LS
Category	Earthen Levee			GPS Latitude/Longitude	
				Start	End
Item	Erosion / Bank Caving			36.974397 °	36.974397 °
				-120.374415 °	-120.374415 °
DWR ID	DWR_NA0010_06_f_2017_77				
Comment Code					
E2 : Schedule repair of erosion site prior to the next inspection.					
Inspector Comment					
Landowner installed a raincoat on landside levee at location of temporary pipe. Need to assess landside slope to determine/repair any possible damage.

Looking southwest at the landside slope.

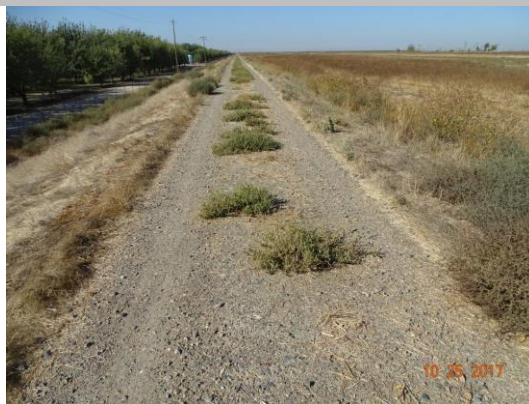
Photo 1 of 1 : SP\_2018\_NA0010\_124\_74\_20180307\_00025.jpg

LM Start	36.28	Rating **	A/W	Issue No.	74
LM End	36.39	Issue Type +	Ma	Location *	CR
Category	Earthen Levee			GPS Latitude/Longitude	
				Start	End
Item	Vegetation			36.974411 °	36.974422 °
				-120.366674 °	-120.364632 °
DWR ID	DWR_NA0010_06_f_2017_74				
Comment Code					
V1 : Control annual grass and weeds on the levee slopes and easements.					
Inspector Comment

Looking west at the levee crown.

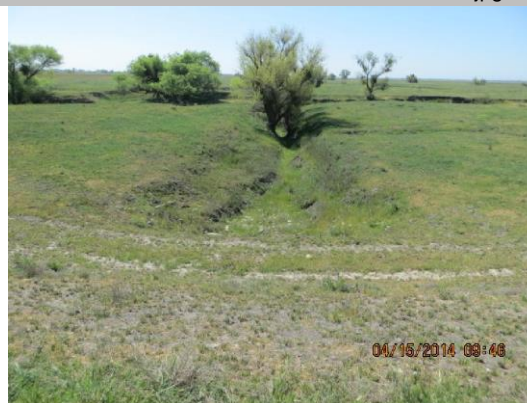
Photo 1 of 3 : UCIP\_SP\_2018\_49966\_60954.jpg

FS\_ID:49966  
DS\_ID:19892  
EP\_NO: N/A  
Repair Type: Non-Urgent  
Crossing Status: Found  
UCIP Comments: 07/20/2016 Inlet blocked off by wooden board. Dense vegetation limits the inspector's visibility to identify signs of pipe failure (leaks) along WS and LS. Crossing downgraded from Urgent to Non-Urgent. (DWR UCIP - omagana)04/15/2014 Flapgate partially blocked by soil buildup at WS toe. (DWR UCIP - omagana)  
FIELD\_STRUCT\_DESC: 24-inch corrugated metal gravity drainage pipe through the levee, 10.8 feet below the crown. Flap gate on the waterside (WS) end. Concrete headwall on the landside (LS) end. Concrete U-shaped headwall on the WS end. [Additional Reference(s): DWR Levee Log, 2002. USACE San Joaquin O&M Manual 601.1, 1967, (HLM 0.07)].  
FS Date: 7/20/2016

Pipe and headwall at WS toe.

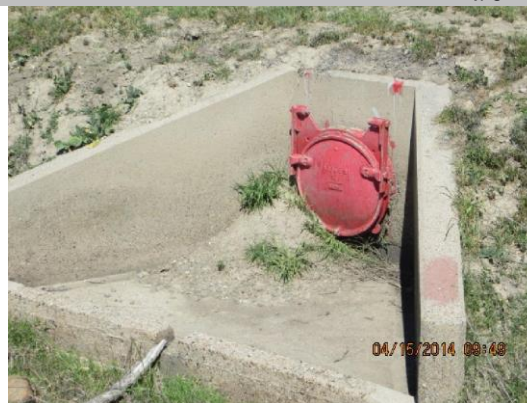
Photo 2 of 3 : UCIP\_SP\_2018\_49966\_60955.jpg

Pipe, headwall, and flapgate at WS toe. Soil buildup partially blocking flapgate.

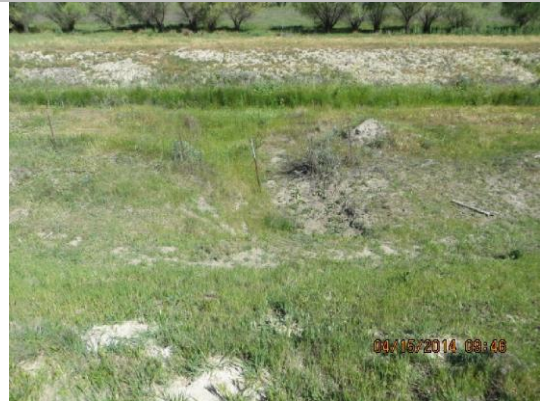
Photo 3 of 3 : UCIP\_SP\_2018\_49966\_60953.jpg

Comment Code						
Inspector Comment						
FS_ID:49966 DS_ID:19892 EP_NO: N/A Repair Type: Non-Urgent Crossing Status: Found UCIP Comments: 07/20/2016 Inlet blocked off by wooden board. Dense vegetation limits the inspector's visibility to identify signs of pipe failure (leaks) along WS and LS. Crossing downgraded from Urgent to Non-Urgent. (DWR UCIP - omagana)04/15/2014 Flapgate partially blocked by soil buildup at WS toe. (DWR UCIP - omagana) FIELD_STRUCT_DESC: 24-inch corrugated metal gravity drainage pipe through the levee, 10.8 feet below the crown. Flap gate on the waterside (WS) end. Concrete headwall on the landside (LS) end. Concrete U-shaped headwall on the WS end. [Additional Reference(s): DWR Levee Log, 2002. USACE San Joaquin O&M Manual 601.1, 1967, (HLM 0.07)]. FS Date: 7/20/2016

Pipe and headwall at LS toe.

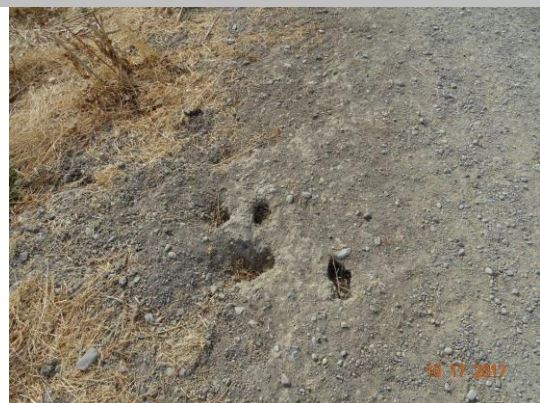
Photo 1 of 2 : SP\_2018\_NA0010\_125\_29\_20180307\_00008.jpg

LM Start	0.24	Rating **	M	Issue No.	29
LM End	0.50	Issue Type +	Ma	Location *	LS
Category	Earthen Levee			GPS Latitude/Longitude	
				Start	End
Item	Animal Control			37.256936 °	37.258722 °
				-120.768472 °	-120.764867 °
DWR ID	DWR_NA0010_07_s_2012_29				
Comment Code					
A3 : No rodents visible, but rodent burrows visible; need to backfill and compact or grout burrows.					
Inspector Comment					
Several rodent holes noted on landside and waterside slope and shoulder.

Looking north at landside slope.

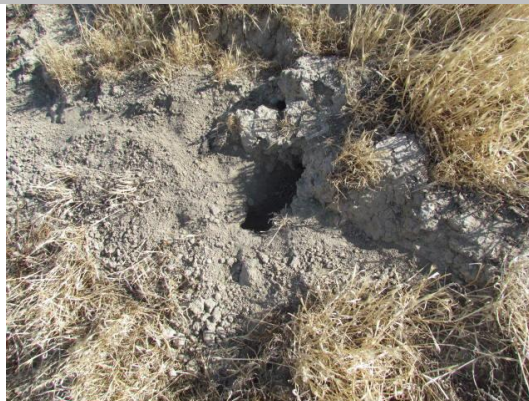
Photo 2 of 2 : SP\_2018\_NA0010\_125\_29\_20180307\_00009.jpg

LM Start	0.24	Rating **	M	Issue No.	29 (cont)	
LM End	0.50	Issue Type +	Ma	Location *	LS	
Category	Earthen Levee			GPS Latitude/Longitude		
				Start		End
Item	Animal Control			37.256936 °		37.258722 °
				-120.768472 °		-120.764867 °
DWR ID	DWR_NA0010_07_s_2012_29					
Comment Code						
A3 : No rodents visible, but rodent burrows visible; need to backfill and compact or grout burrows.						
Inspector Comment						
Several rodent holes noted on landside and waterside slope and shoulder.

Looking at typical view of rodent holes on landward slope.

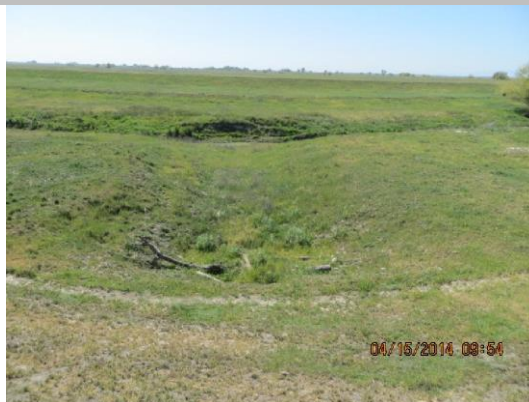
Photo 1 of 3 : UCIP\_SP\_2018\_33712\_60958.jpg

Pipe and headwall on WS toe.

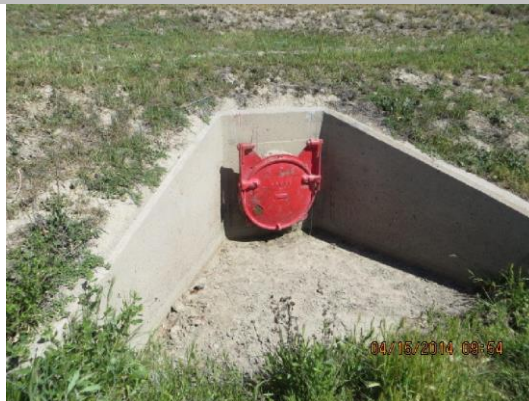
Photo 2 of 3 : UCIP\_SP\_2018\_33712\_60957.jpg

Pipe, headwall, and flapgate on WS toe.

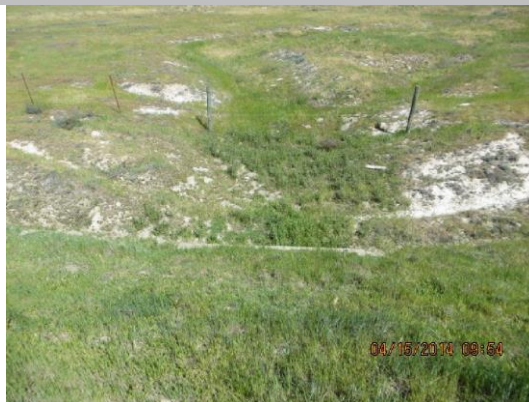
Photo 3 of 3 : UCIP\_SP\_2018\_33712\_60959.jpg

Pipe and headwall on LS toe.

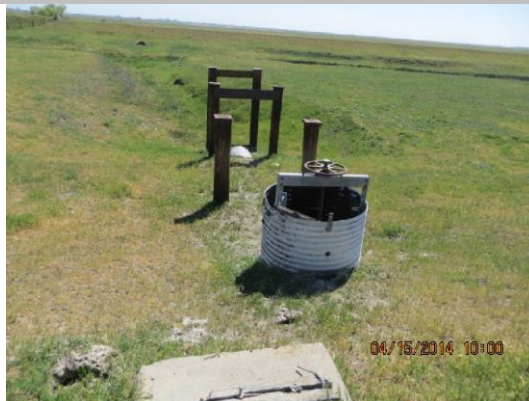
Photo 1 of 3 : UCIP\_SP\_2018\_33713\_60963.jpg

FS\_ID:33713  
DS\_ID:19894  
EP\_NO: N/A  
Repair Type: Non-Urgent  
Crossing Status: Found  
UCIP Comments: Slide gate not operable, but left in closed position.  
Need to reinstall covers over slide gate standpipe.  
FIELD\_STRUCT\_DESC: 36-inch corrugated metal gravity drainage pipe through the levee, 9.7 feet below the crown. Slide gate in a 48-inch corrugated metal pipe (CMP) riser on the landside (LS) slope. Concrete U-shaped headwall on the LS end. Inlet channel cobble revetted. Dilapidated wooden pier on the waterside (WS). WS slope and outlet ditch cobble revetted. [Additional Reference(s): DWR Levee Log, 2002. USACE San Joaquin O&M Manual 601.1, 1967, (HLM 0.49)].  
FS Date: 4/15/2014

Slide gate in CMP riser on WS slope.

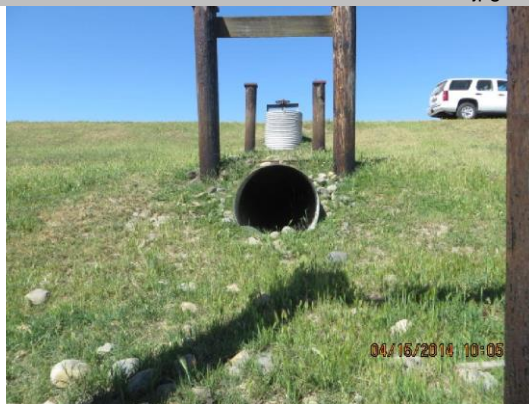
Photo 2 of 3 : UCIP\_SP\_2018\_33713\_60965.jpg

Outlet on WS slope.

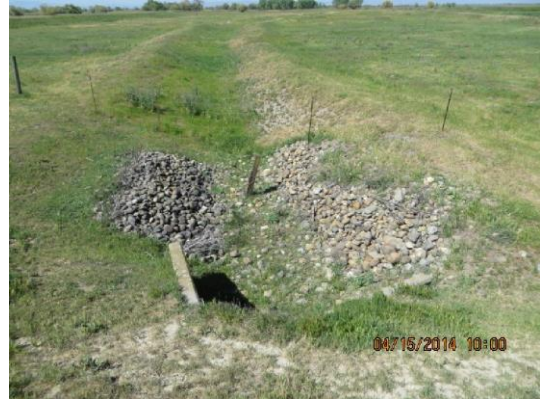
Photo 3 of 3 : UCIP\_SP\_2018\_33713\_60964.jpg

Comment Code						
Inspector Comment						
FS_ID:33713						
DS_ID:19894						
EP_NO: N/A						
Repair Type: Non-Urgent						
Crossing Status: Found						
UCIP Comments: Slide gate not operable, but left in closed position.						
Need to reinstall covers over slide gate standpipe.						
FIELD_STRUCT_DESC: 36-inch corrugated metal gravity drainage pipe						
through the levee, 9.7 feet below the crown. Slide gate in a 48-inch						
corrugated metal pipe (CMP) riser on the landside (LS) slope. Concrete						
U-shaped headwall on the LS end. Inlet channel cobble revetted.						
Dilapidated wooden pier on the waterside (WS). WS slope and outlet						
ditch cobble revetted. [Additional Reference(s): DWR Levee Log, 2002.						
USACE San Joaquin O&M Manual 601.1, 1967, (HLM 0.49)].						
FS Date: 4/15/2014

Pipe and headwall on LS toe.

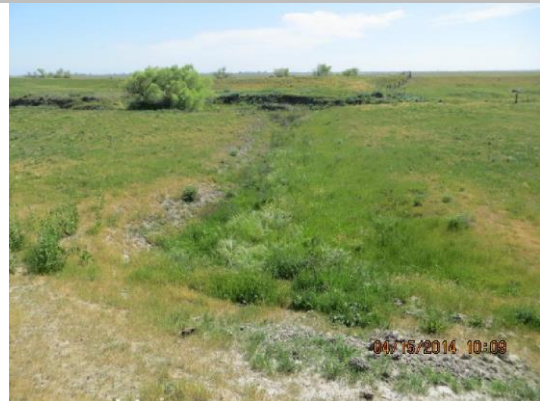
Photo 1 of 3 : UCIP\_SP\_2018\_33723\_60981.jpg

Headwall and flapgate on WS toe.

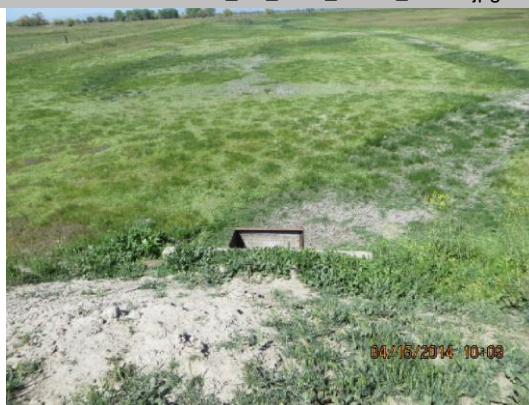
Photo 3 of 3 : UCIP\_SP\_2018\_33723\_60982.jpg

Headwall, pipe, and wier on LS toe.

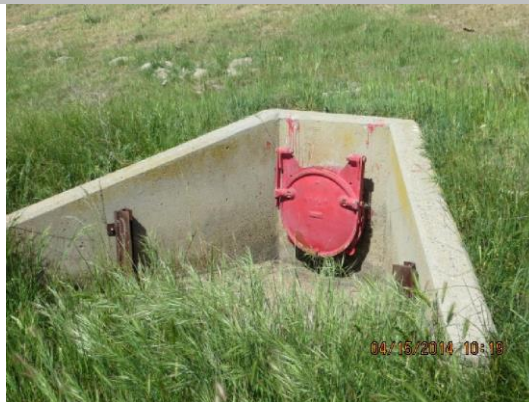
Photo 2 of 3 : UCIP\_SP\_2018\_39507\_60988.jpg

Headwall and flapgate on WS toe.

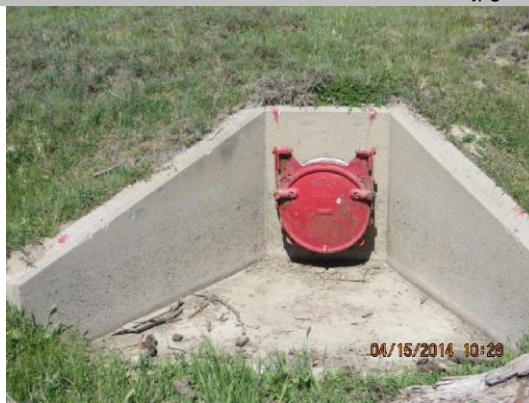
Photo 2 of 3 : UCIP\_SP\_2018\_33725\_60993.jpg

Concrete headwall and flapgate at WS toe.

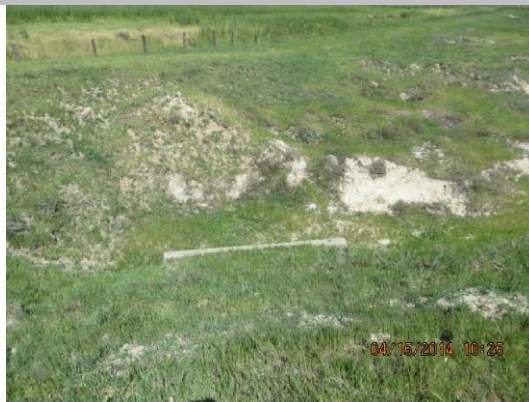
Photo 3 of 3 : UCIP\_SP\_2018\_33725\_60992.jpg

Concrete headwall and pipe on LS toe.

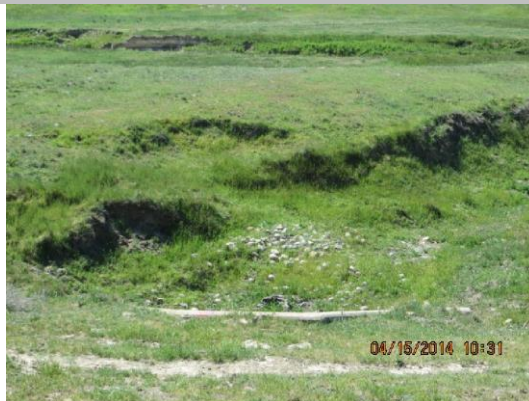
Photo 1 of 3 : UCIP\_SP\_2018\_33726\_60996.jpg

Pipe, flapgate, and headwall on WS toe.

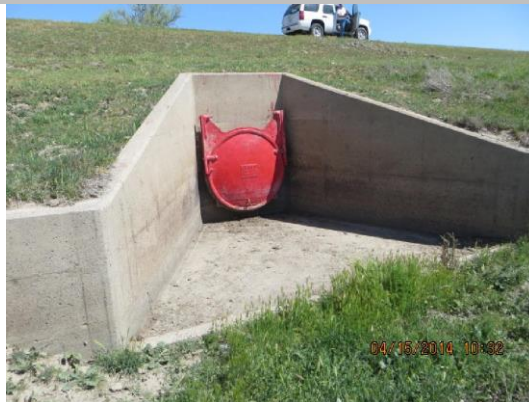
Photo 2 of 3 : UCIP\_SP\_2018\_33726\_60995.jpg

Flapgate at headwall on WS toe.

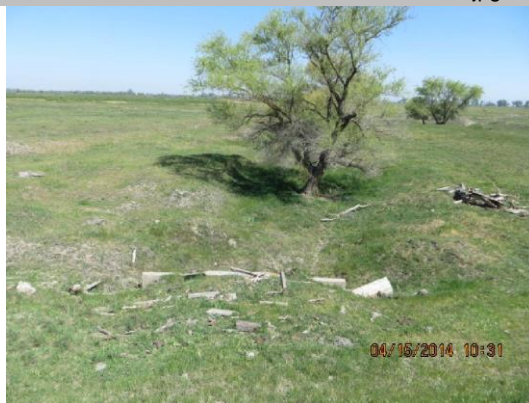
Photo 3 of 3 : UCIP\_SP\_2018\_33726\_60997.jpg

Pipe and headwall on LS toe.

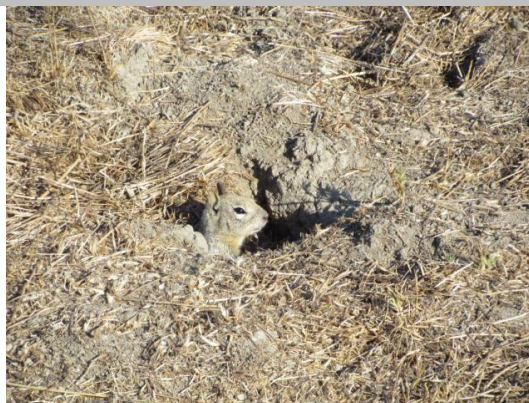
Photo 2 of 2 : SP\_2018\_NA0010\_125\_1\_20180307\_00002.jpg

LM Start	1.22	Rating **	M	Issue No.	1 (cont)	
LM End	1.22	Issue Type +	Ma	Location *	LS	
Category	Earthen Levee			GPS Latitude/Longitude		
				Start		End
Item	Animal Control			37.264387 °		37.264387 °
				-120.755805 °		-120.755805 °
DWR ID	DWR_NA0010_07_f_2012_1					
Comment Code						
A1 : Exterminate rodents and backfill and compact or grout burrows.						
Inspector Comment

Looking at east at active rodent holes on landside berm.

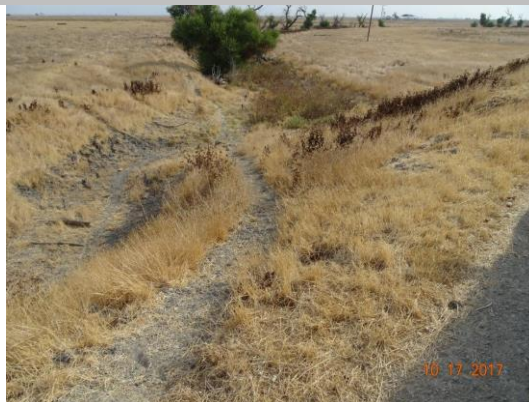
Photo 1 of 1 : SP\_2018\_NA0010\_125\_16\_20180307\_00006.jpg

LM Start	1.49	Rating **	M	Issue No.	16
LM End	1.49	Issue Type +	Ma	Location *	LS
Category	Earthen Levee			GPS Latitude/Longitude	
				Start	End
Item	Slope Stability			37.263999 °	37.263999 °
				-120.750854 °	-120.750854 °
DWR ID	DWR_NA0010_07_f_2017_16				
Comment Code					
S2 : Repair the levee slope damaged by foot traffic and prevent access where possible.					
Inspector Comment					
Repair slope damaged by animal traffic.

Looking east at landside slope.

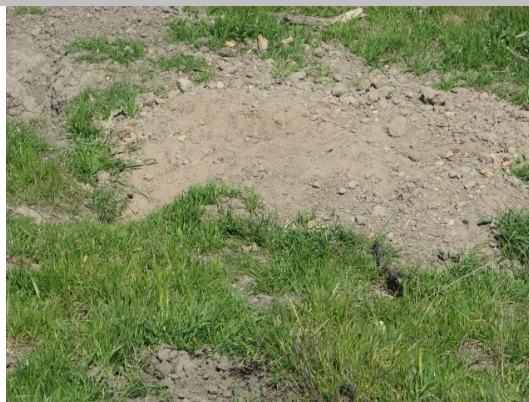
Photo 1 of 2 : SP\_2018\_NA0010\_125\_6\_20180411\_00043.jpg

LM Start	1.50	Rating **	M	Issue No.	6
LM End	1.51	Issue Type +	Ma	Location *	LS
Category	Earthen Levee			GPS Latitude/Longitude	
				Start	End
Item	Animal Control			37.263955 °	37.263885 °
				-120.750751 °	-120.750527 °
DWR ID	DWR_NA0010_07_s_2014_6				
Comment Code					
A1 : Exterminate rodents and backfill and compact or grout burrows.					
Inspector Comment

Looking at typical view of rodent holes within this section. (Spring 2018)

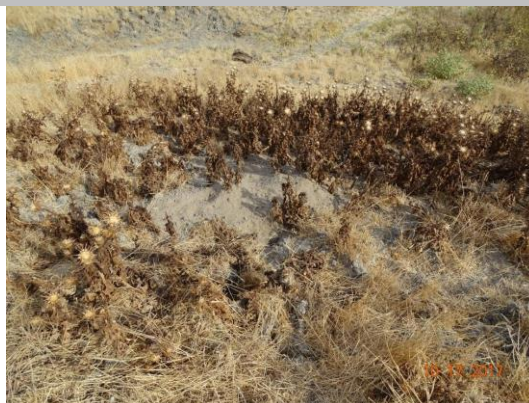
Photo 2 of 2 : SP\_2018\_NA0010\_125\_6\_20180307\_00003.jpg

LM Start	1.50	Rating **	M	Issue No.	6 (cont)	
LM End	1.51	Issue Type +	Ma	Location *	LS	
Category	Earthen Levee			GPS Latitude/Longitude		
				Start		End
Item	Animal Control			37.263955 °		37.263885 °
				-120.750751 °		-120.750527 °
DWR ID	DWR_NA0010_07_s_2014_6					
Comment Code						
A1 : Exterminate rodents and backfill and compact or grout burrows.						
Inspector Comment

Looking northwest at landside slope.

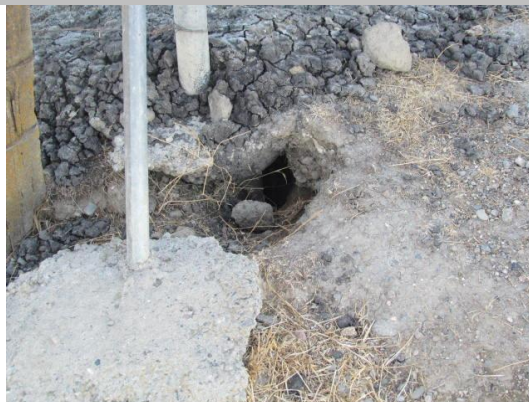
Photo 1 of 2 : SP\_2018\_NA0010\_125\_12\_20180307\_00004.jpg

LM Start	2.09	Rating **	M	Issue No.	12
LM End	2.09	Issue Type +	Ma	Location *	LS
Category	Earthen Levee			GPS Latitude/Longitude	
				Start	End
Item	Animal Control			37.259187 °	37.259187 °
				-120.742551 °	-120.742551 °
DWR ID	DWR_NA0010_07_f_2014_12				
Comment Code					
A3 : No rodents visible, but rodent burrows visible; need to backfill and compact or grout burrows.					
Inspector Comment					
Rodent activity noted next to fence post.

Looking east at rodent hole next to fence post on landward shoulder.

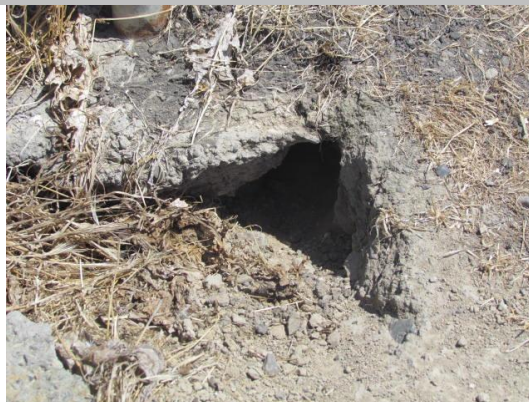
Photo 2 of 2 : SP\_2018\_NA0010\_125\_12\_20180307\_00005.jpg

Looking at rodent activity next to fence post

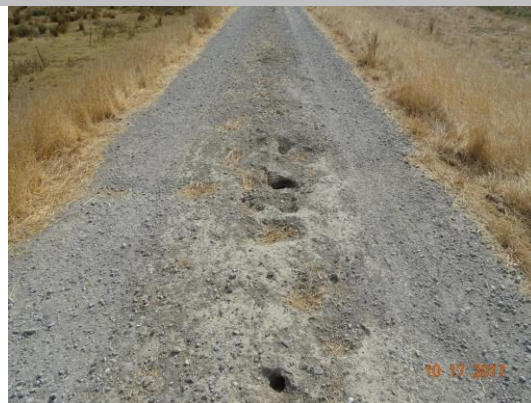
Photo 1 of 1 : SP\_2018\_NA0010\_125\_17\_20180307\_00007.jpg

LM Start	2.12	Rating **	M	Issue No.	17
LM End	2.18	Issue Type +	Ma	Location *	CR
Category	Earthen Levee			GPS Latitude/Longitude	
				Start	End
Item	Animal Control			37.259007 °	37.258726 °
				-120.742050 °	-120.741118 °
DWR ID	DWR_NA0010_07_f_2017_17				
Comment Code					
A3 : No rodents visible, but rodent burrows visible; need to backfill and compact or grout burrows.					
Inspector Comment

Looking southeast at the crown.

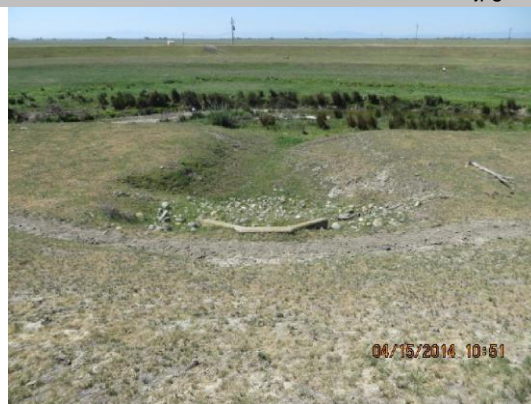
Photo 1 of 3 : UCIP\_SP\_2018\_33728\_61006.jpg

LM Start	2.48	Rating **	A/W	Issue No.	38
LM End	2.48	Issue Type +	Ma	Location *	
Category	Supplemental			GPS Latitude/Longitude	
				Start	End
Item	DWR UCIP LMA Responsibility			37.255803 °	37.255803 °
				-120.737246 °	-120.737246 °
DWR ID					
Comment Code					
Inspector Comment					
FS_ID:33728					
DS_ID:19899					
EP_NO: N/A					
Repair Type: No Action Needed					
Crossing Status: Found					
UCIP Comments:					
FIELD_STRUCT_DESC: 24-inch corrugated metal gravity drainage pipe through the levee, 9.5 feet below the crown. Flap gate on the waterside (WS) end. Concrete headwall on the landside (LS) end. Concrete U-shaped headwall on the WS end. [Additional Reference(s): DWR Levee Log, 2002. USACE San Joaquin O&M Manual 601.1, 1967, (HLM 2.48)].					
FS Date: 4/15/2014

Headwall and flapgate on WS toe.

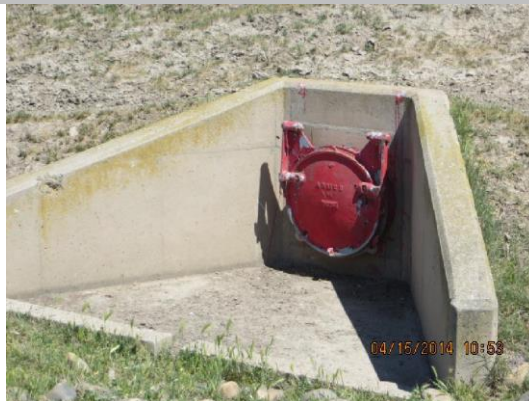
Photo 2 of 3 : UCIP\_SP\_2018\_33728\_61008.jpg

FS\_ID:33728  
DS\_ID:19899  
EP\_NO: N/A  
Repair Type: No Action Needed  
Crossing Status: Found  
UCIP Comments:  
FIELD\_STRUCT\_DESC: 24-inch corrugated metal gravity drainage pipe through the levee, 9.5 feet below the crown. Flap gate on the waterside (WS) end. Concrete headwall on the landside (LS) end. Concrete U-shaped headwall on the WS end. [Additional Reference(s): DWR Levee Log, 2002. USACE San Joaquin O&M Manual 601.1, 1967, (HLM 2.48)].  
FS Date: 4/15/2014

Concrete headwall and flapgate at WS toe.

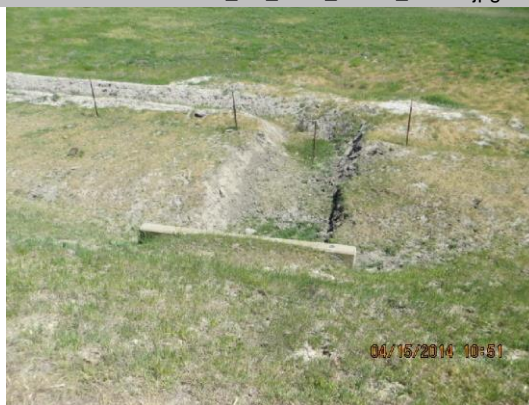
Photo 3 of 3 : UCIP\_SP\_2018\_33728\_61007.jpg

Concrete headwall and pipe on LS toe.
