**Flood Control Project Maintenance  
Levee Inspections**

## Maintenance Issue Types Only, Levee Inspection Report By Mile - Spring 2018

### Lower San Joaquin Levee District

Waterway	Bank	Unit Miles	Inspection Start/End	Inspector
Unit No. 01 San Joaquin River	Right	22.52	04/04/2018 04/16/2018	Richard Willoughby

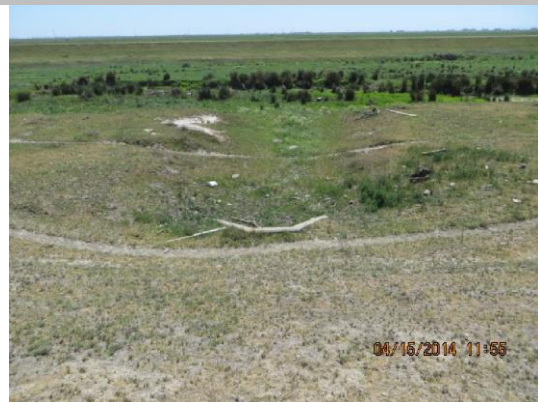
Photo 1 of 3 : UCIP\_SP\_2018\_39508\_61016.jpg

LM Start	3.09	Rating **	M	Issue No.	40	
LM End	3.09	Issue Type +	Ma	Location *		
Category	Supplemental			GPS Latitude/Longitude		
				Start		End
Item	DWR UCIP LMA Responsibility			37.251883 °		37.251883 °
				-120.728264 °		-120.728264 °
DWR ID						
Comment Code						
Inspector Comment						
FS_ID:39508 DS_ID:19901 EP_NO: N/A Repair Type: Non-Urgent Crossing Status: Found UCIP Comments: Some sediment buildup at landward toe and inside pipe--recommend clearing. FIELD_STRUCT_DESC: 24-inch corrugated metal gravity drainage pipe through the levee, 10.4 feet below the crown. Flap gate on the waterside (WS) end. Concrete headwall on the landside (LS) end. Concrete U-shaped headwall on the WS end. [Additional Reference(s): DWR Levee Log, 2002. USACE San Joaquin O&M Manual 601.1, 1967, (HLM 3.09)]. FS Date: 4/15/2014

Headwall, pipe, and flapgate on WS toe.

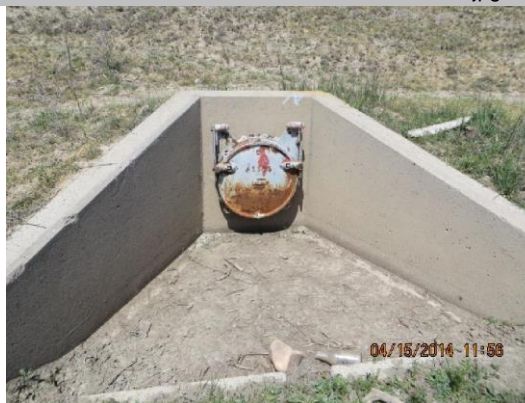
Photo 2 of 3 : UCIP\_SP\_2018\_39508\_61015.jpg

Headwall, pipe, and flapgate on WS toe.

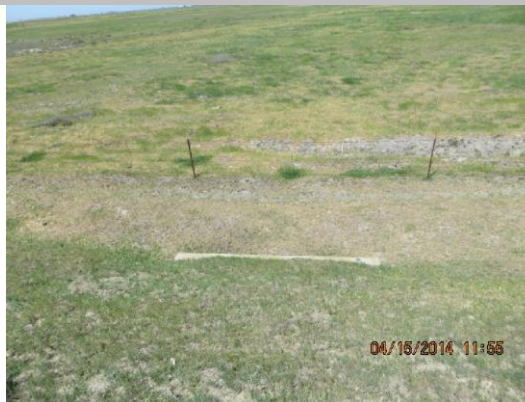
Photo 3 of 3 : UCIP\_SP\_2018\_39508\_61017.jpg

Headwall and pipe on LS toe.

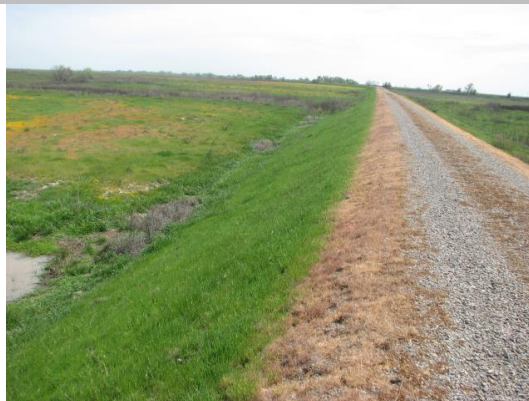
Photo 1 of 1 : SP\_2018\_NA0010\_126\_20\_20180411\_00043.jpg

LM Start	0.00	Rating **	M	Issue No.	20
LM End	3.63	Issue Type +	Ma	Location *	LS
Category	Earthen Levee			GPS Latitude/Longitude	
				Start	End
Item	Vegetation			37.253103 °	37.254137 °
				-120.768464 °	-120.718851 °
DWR ID	DWR_NA0010_08_s_2018_20				
Comment Code					
V1 : Control annual grass and weeds on the levee slopes and easements.					
Inspector Comment

Looking east at typical view of landward slope. (Spring 2018)

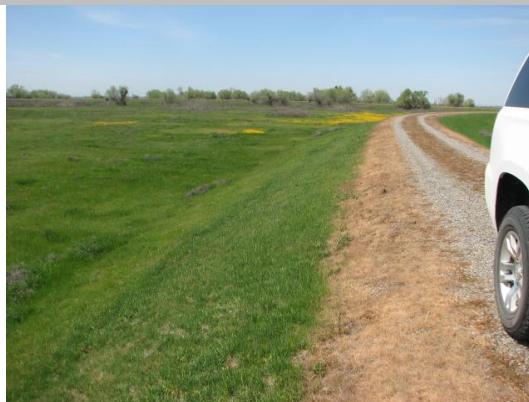
Photo 1 of 1 : SP\_2018\_NA0010\_126\_21\_20180411\_00044.jpg

LM Start	0.00	Rating **	M	Issue No.	21
LM End	3.63	Issue Type +	Ma	Location *	WS
Category	Earthen Levee			GPS Latitude/Longitude	
				Start	End
Item	Vegetation			37.253104 °	37.254136 °
				-120.768464 °	-120.718851 °
DWR ID	DWR_NA0010_08_s_2018_21				
Comment Code					
V1 : Control annual grass and weeds on the levee slopes and easements.					
Inspector Comment

Looking west at typical view of waterward slope. (Spring 2018)

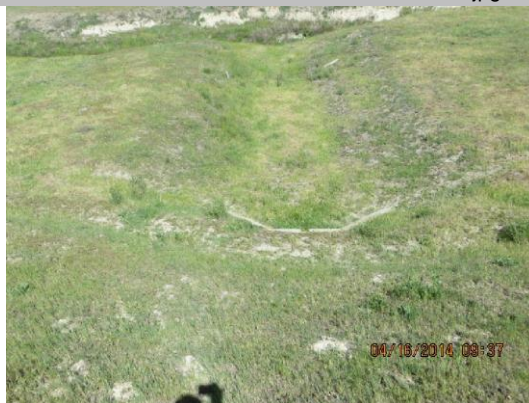
Photo 1 of 3 : UCIP\_SP\_2018\_33751\_61068.jpg

FS\_ID:33751  
DS\_ID:19903  
EP\_NO: N/A  
Repair Type: No Action Needed  
Crossing Status: Found  
UCIP Comments:  
FIELD\_STRUCT\_DESC: 24-inch corrugated metal gravity drainage pipe through the levee, 9.6 feet below the crown. Flap gate on the waterside (WS) end. Concrete headwall on the landside (LS) end. Concrete U-shaped headwall on the WS end. [Additional Reference(s): DWR Levee Log, 2002. USACE San Joaquin O&M Manual 601.1, 1967, (HLM 0.23)].  
FS Date: 4/16/2014

Headwall and flapgate on WS toe.

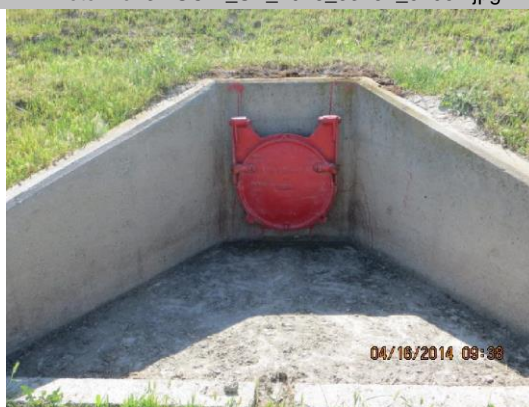
Photo 2 of 3 : UCIP\_SP\_2018\_33751\_61067.jpg

Headwall and flapgate on WS toe.

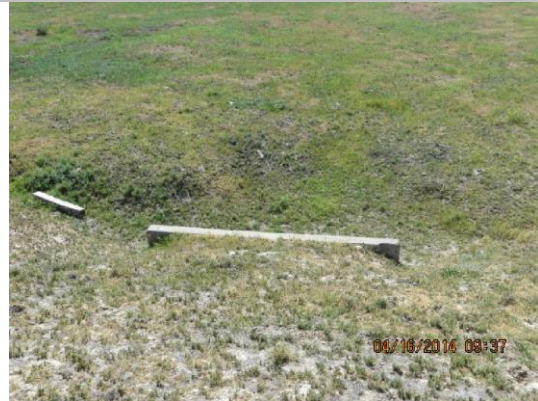
Photo 3 of 3 : UCIP\_SP\_2018\_33751\_61069.jpg

LM Start	0.23	Rating **	A/W	Issue No.	22 (cont)	
LM End	0.23	Issue Type +	Ma	Location *		
Category	Supplemental			GPS Latitude/Longitude		
				Start	End	
Item	DWR UCIP LMA Responsibility			37.256092 °	37.256092 °	
				-120.767873 °	-120.767873 °	
DWR ID						
Comment Code						
Inspector Comment						
FS_ID:33751						
DS_ID:19903						
EP_NO: N/A						
Repair Type: No Action Needed						
Crossing Status: Found						
UCIP Comments:						
FIELD_STRUCT_DESC: 24-inch corrugated metal gravity drainage pipe						
through the levee, 9.6 feet below the crown. Flap gate on the waterside						
(WS) end. Concrete headwall on the landside (LS) end. Concrete U-						
shaped headwall on the WS end. [Additional Reference(s): DWR Levee						
Log, 2002. USACE San Joaquin O&M Manual 601.1, 1967, (HLM 0.23)].						
FS Date: 4/16/2014

Concrete headwall on LS toe.

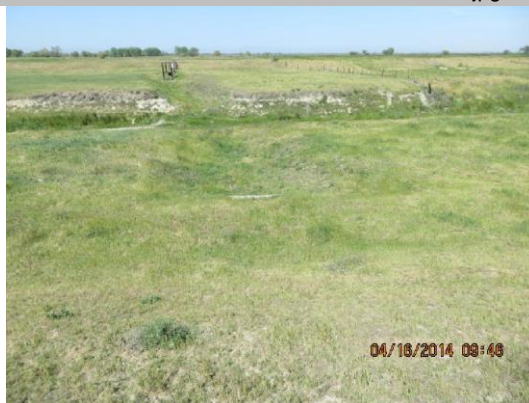
Photo 1 of 3 : UCIP\_SP\_2018\_33752\_61073.jpg

LM Start	0.57	Rating **	A/W	Issue No.	23
LM End	0.57	Issue Type +	Ma	Location *	
Category	Supplemental			GPS Latitude/Longitude	
				Start	End
Item	DWR UCIP LMA Responsibility			37.258604 °	37.258604 °
				-120.763588 °	-120.763588 °
DWR ID					
Comment Code					
Inspector Comment					
FS_ID:33752 DS_ID:19904 EP_NO: N/A Repair Type: No Action Needed Crossing Status: Found UCIP Comments: FIELD_STRUCT_DESC: 24-inch corrugated metal gravity drainage pipe through the levee, 12.4 feet below the crown. Flap gate on the waterside (WS) end. Concrete headwall on each end. [Additional Reference(s): DWR Levee Log, 2002. USACE San Joaquin O&M Manual 601.1, 1967, (HLM 0.57)]. FS Date: 4/16/2014

Pipe, flapgate and headwall on WS toe.

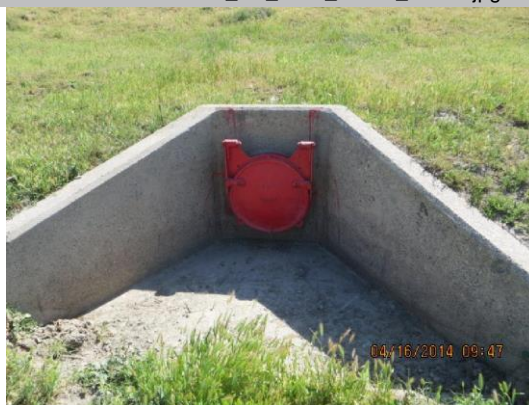
Photo 2 of 3 : UCIP\_SP\_2018\_33752\_61072.jpg

Pipe, flapgate and headwall on WS toe.

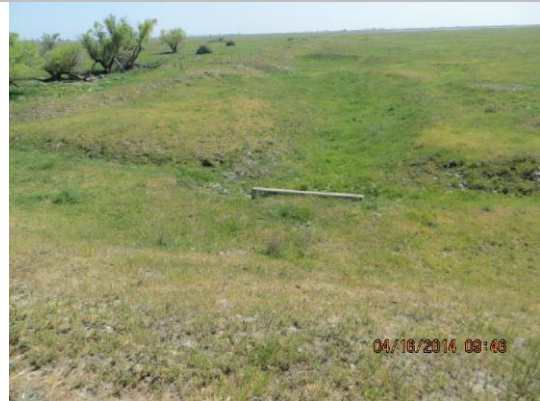
Photo 3 of 3 : UCIP\_SP\_2018\_33752\_61074.jpg

LM Start	0.57	Rating **	A/W	Issue No.	23 (cont)	
LM End	0.57	Issue Type +	Ma	Location *		
Category	Supplemental			GPS Latitude/Longitude		
				Start	End	
Item	DWR UCIP LMA Responsibility			37.258604 °	37.258604 °	
				-120.763588 °	-120.763588 °	
DWR ID						
Comment Code						
Inspector Comment						
FS_ID:33752						
DS_ID:19904						
EP_NO: N/A						
Repair Type: No Action Needed						
Crossing Status: Found						
UCIP Comments:						
FIELD_STRUCT_DESC: 24-inch corrugated metal gravity drainage pipe						
through the levee, 12.4 feet below the crown. Flap gate on the						
waterside (WS) end. Concrete headwall on each end. [Additional						
Reference(s): DWR Levee Log, 2002. USACE San Joaquin O&M						
Manual 601.1, 1967, (HLM 0.57)].						
FS Date: 4/16/2014

Pipe and headwall on LS toe.

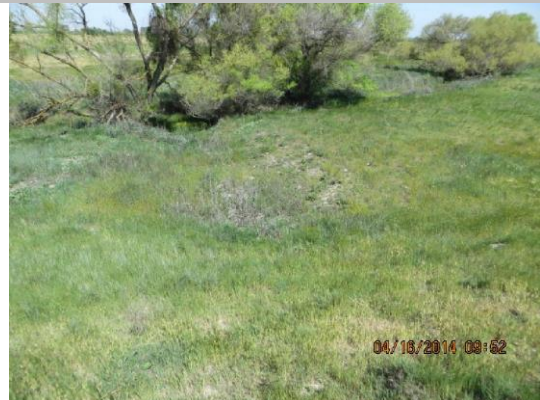
Photo 1 of 3 : UCIP\_SP\_2018\_33753\_61078.jpg

LM Start	0.72	Rating **	A/W	Issue No.	24
LM End	0.72	Issue Type +	Ma	Location *	
Category	Supplemental			GPS Latitude/Longitude	
				Start	End
Item	DWR UCIP LMA Responsibility			37.260306 °	37.260306 °
				-120.762127 °	-120.762127 °
DWR ID					
Comment Code					
Inspector Comment					
FS_ID:33753 DS_ID:19905 EP_NO: N/A Repair Type: No Action Needed Crossing Status: Found UCIP Comments: FIELD_STRUCT_DESC: 24-inch corrugated metal gravity drainage pipe through the levee, 10 feet below the crown. Flap gate on the waterside (WS) end. Concrete headwall on each end. [Additional Reference(s): DWR Levee Log, 2002. USACE San Joaquin O&M Manual 601.1, 1967, (HLM 0.72)]. FS Date: 4/16/2014

Headwall and flapgate at WS toe.

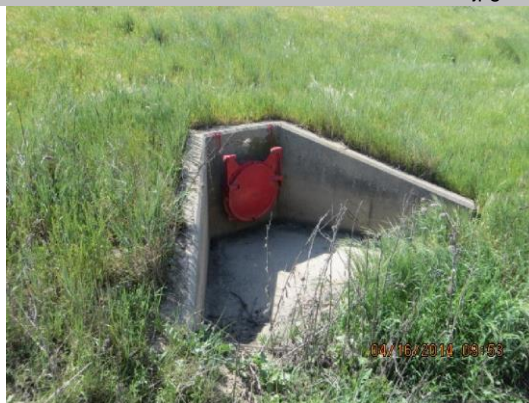
Photo 2 of 3 : UCIP\_SP\_2018\_33753\_61080.jpg

LM Start	0.72	Rating **	A/W	Issue No.	24 (cont)	
LM End	0.72	Issue Type +	Ma	Location *		
Category	Supplemental			GPS Latitude/Longitude		
				Start	End	
Item	DWR UCIP LMA Responsibility			37.260306 °	37.260306 °	
				-120.762127 °	-120.762127 °	
DWR ID						
Comment Code						
Inspector Comment						
FS_ID:33753 DS_ID:19905 EP_NO: N/A Repair Type: No Action Needed Crossing Status: Found UCIP Comments: FIELD_STRUCT_DESC: 24-inch corrugated metal gravity drainage pipe through the levee, 10 feet below the crown. Flap gate on the waterside (WS) end. Concrete headwall on each end. [Additional Reference(s): DWR Levee Log, 2002. USACE San Joaquin O&M Manual 601.1, 1967, (HLM 0.72)]. FS Date: 4/16/2014

Headwall and flapgate at WS toe.

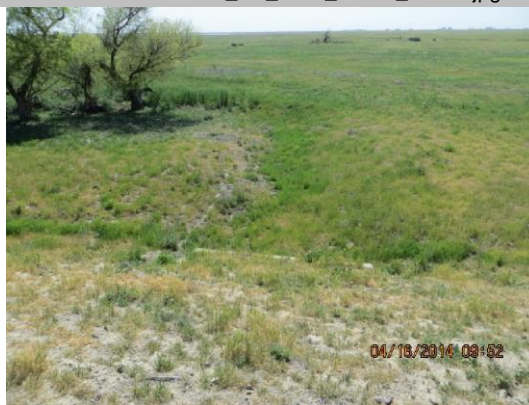
Photo 3 of 3 : UCIP\_SP\_2018\_33753\_61079.jpg

Concrete headwall on LS toe.

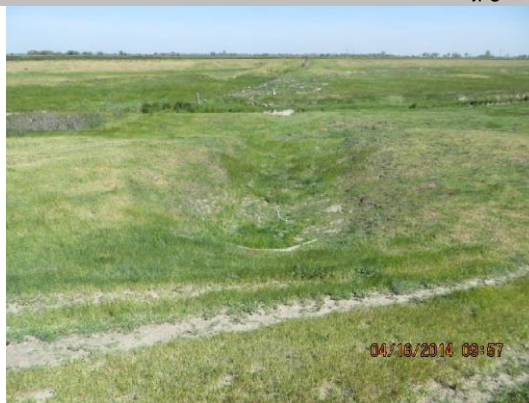
Photo 1 of 3 : UCIP\_SP\_2018\_39887\_61084.jpg

LM Start	0.90	Rating **	M	Issue No.	25
LM End	0.90	Issue Type +	Ma	Location *	
Category	Supplemental			GPS Latitude/Longitude	
				Start	End
Item	DWR UCIP LMA Responsibility			37.262384 °	37.262384 °
				-120.760528 °	-120.760528 °
DWR ID					
Comment Code					
Inspector Comment					
FS_ID:39887					
DS_ID:19832					
EP_NO: N/A					
Repair Type: Non-Urgent					
Crossing Status: Found					
UCIP Comments: Some sediment buildup at inlet on LS toe.					
FIELD_STRUCT_DESC: 24-inch corrugated metal gravity drainage pipe					
through the levee, 11.5 feet below the crown. Flap gate on the					
waterside (WS) end. Concrete headwall on each end. [Additional					
Reference(s): DWR Levee Log, 2002. USACE San Joaquin O&M					
Manual 601.1, 1967, (HLM 0.89)].					
FS Date: 4/16/2014

Headwall, pipe, and flapgate on WS toe.

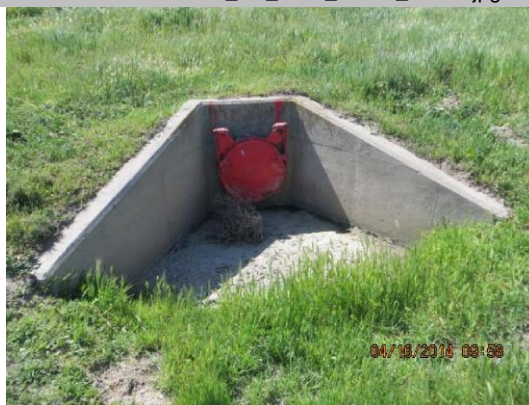
Photo 2 of 3 : UCIP\_SP\_2018\_39887\_61083.jpg

Headwall, pipe, and flapgate on WS toe.

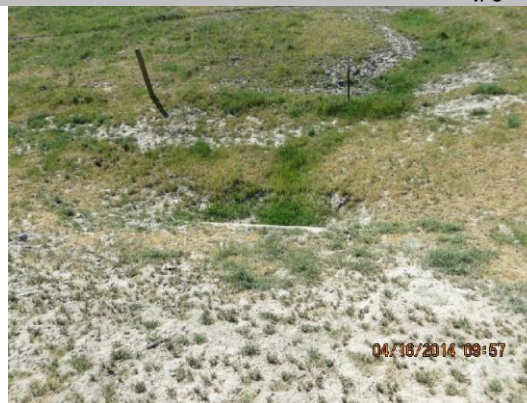
Photo 3 of 3 : UCIP\_SP\_2018\_39887\_61085.jpg

LM Start	0.90	Rating **	M	Issue No.	25 (cont)	
LM End	0.90	Issue Type +	Ma	Location *		
Category	Supplemental			GPS Latitude/Longitude		
				Start	End	
Item	DWR UCIP LMA Responsibility			37.262384 °	37.262384 °	
				-120.760528 °	-120.760528 °	
DWR ID						
Comment Code						
Inspector Comment						
FS_ID:39887						
DS_ID:19832						
EP_NO: N/A						
Repair Type: Non-Urgent						
Crossing Status: Found						
UCIP Comments: Some sediment buildup at inlet on LS toe.						
FIELD_STRUCT_DESC: 24-inch corrugated metal gravity drainage pipe						
through the levee, 11.5 feet below the crown. Flap gate on the						
waterside (WS) end. Concrete headwall on each end. [Additional						
Reference(s): DWR Levee Log, 2002. USACE San Joaquin O&M						
Manual 601.1, 1967, (HLM 0.89)].						
FS Date: 4/16/2014

Pipe and headwall on LS toe.

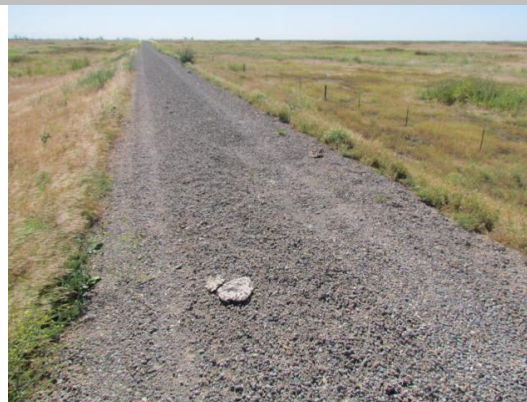
Photo 1 of 1 : SP\_2018\_NA0010\_126\_5\_20180307\_00004.jpg

LM Start	1.16	Rating **	A/W	Issue No.	5
LM End	3.18	Issue Type +	Ma	Location *	CR
Category	Earthen Levee			GPS Latitude/Longitude	
				Start	End
Item	Crown Surface / Depressions / Rutting			37.263243 °	37.251737 °
				-120.756372 °	-120.726246 °
DWR ID	DWR_NA0010_08_s_2016_5				
Comment Code					
C2 : Repair depressions or ruts in the crown or slope.					
Inspector Comment					
Depression noted on levee crown.

Looking west at depression on toward landward shoulder.

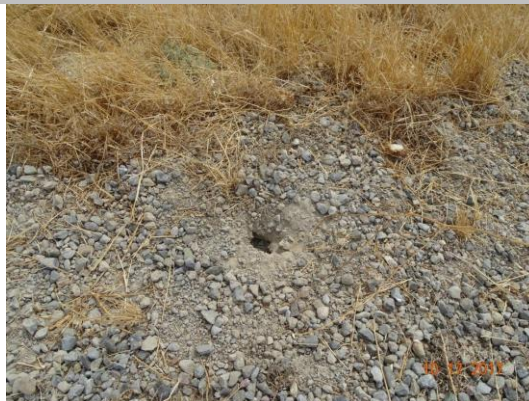
Photo 1 of 1 : SP\_2018\_NA0010\_126\_2\_20180307\_00001.jpg

LM Start	1.20	Rating **	M	Issue No.	2
LM End	1.20	Issue Type +	Ma	Location *	LS
Category	Earthen Levee			GPS Latitude/Longitude	
				Start	End
Item	Animal Control			37.263182 °	37.263183 °
				-120.755650 °	-120.755637 °
DWR ID	DWR_NA0010_08_s_2012_2				
Comment Code					
A3 : No rodents visible, but rodent burrows visible; need to backfill and compact or grout burrows.					
Inspector Comment

Looking south at the landside shoulder.

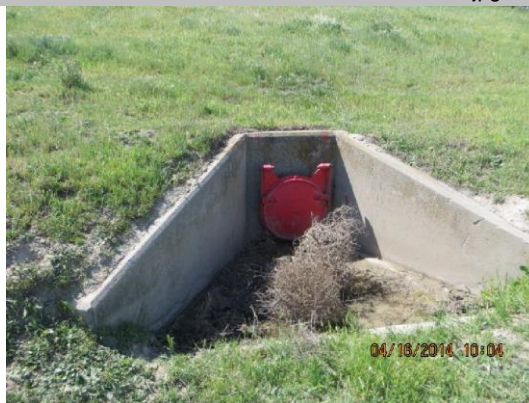
Photo 2 of 3 : UCIP\_SP\_2018\_39509\_61091.jpg

LM Start	1.21	Rating **	M	Issue No.	26 (cont)
LM End	1.21	Issue Type +	Ma	Location *	
Category	Supplemental			GPS Latitude/Longitude	
				Start	End
Item	DWR UCIP LMA Responsibility			37.263188 °	37.263188 °
				-120.755399 °	-120.755399 °
DWR ID					
Comment Code					
Inspector Comment					
FS_ID:39509					
DS_ID:19833					
EP_NO: N/A					
Repair Type: Non-Urgent					
Crossing Status: Found					
UCIP Comments: Debris blocking landward headwall--recommend clearing.					
FIELD_STRUCT_DESC: 24-inch corrugated metal gravity drainage pipe through the levee, 11.6 feet below the crown. Flap gate on the waterside (WS) end. Concrete headwall on each end. [Additional Reference(s): DWR Levee Log, 2002. USACE San Joaquin O&M Manual 601.1, 1967, (HLM 1.21)].					
FS Date: 4/16/2014

Concrete headwall, pipe, and flapgate on WS toe.

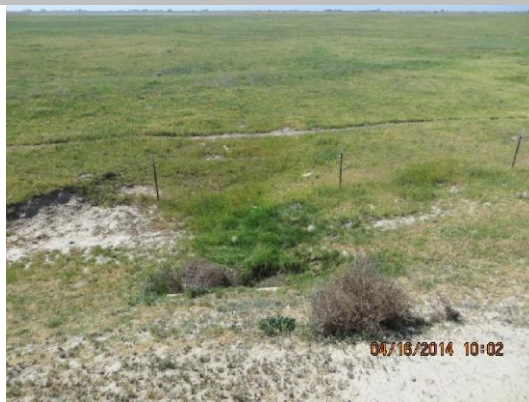
Photo 3 of 3 : UCIP\_SP\_2018\_39509\_61089.jpg

Pipe and headwall on LS toe.

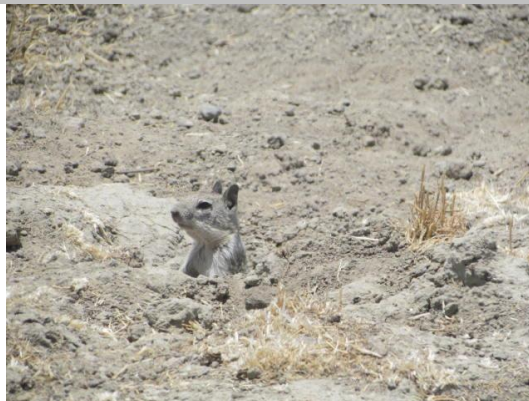
Photo 1 of 1 : SP\_2018\_NA0010\_126\_8\_20180307\_00006.jpg

LM Start	1.38	Rating **	M	Issue No.	8
LM End	1.38	Issue Type +	Ma	Location *	LS
Category	Earthen Levee			GPS Latitude/Longitude	
				Start	End
Item	Animal Control			37.263175 °	37.263175 °
				-120.752307 °	-120.752307 °
DWR ID	DWR_NA0010_08_s_2013_8				
Comment Code					
A1 : Exterminate rodents and backfill and compact or grout burrows.					
Inspector Comment

Looking west at rodent holes on landward slope.

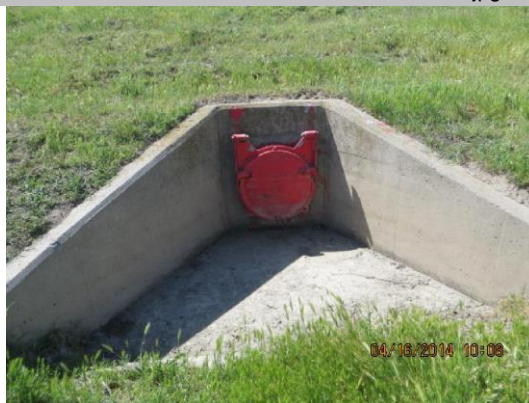
Photo 2 of 3 : UCIP\_SP\_2018\_39510\_61093.jpg

LM Start	1.38	Rating **	M	Issue No.	27 (cont)
LM End	1.38	Issue Type +	Ma	Location *	
Category	Supplemental			GPS Latitude/Longitude	
				Start	End
Item	DWR UCIP LMA Responsibility			37.263194 °	37.263194 °
				-120.752299 °	-120.752299 °
DWR ID					
Comment Code					
Inspector Comment					
FS_ID:39510 DS_ID:19834 EP_NO: N/A Repair Type: Non-Urgent Crossing Status: Found UCIP Comments: Animal burrows along pipe alignment on LS. Some sediment buildup at LS toe and inside pipe--recommend clearing. FIELD_STRUCT_DESC: 24-inch corrugated metal gravity drainage pipe through the levee, 11.5 feet below the crown. Flap gate on the waterside (WS) end. Concrete headwall on each end. [Additional Reference(s): DWR Levee Log, 2002. USACE San Joaquin O&M Manual 601.1, 1967, (HLM 1.38)]. FS Date: 4/16/2014

Pipe, headwall, and flapgate on WS toe.

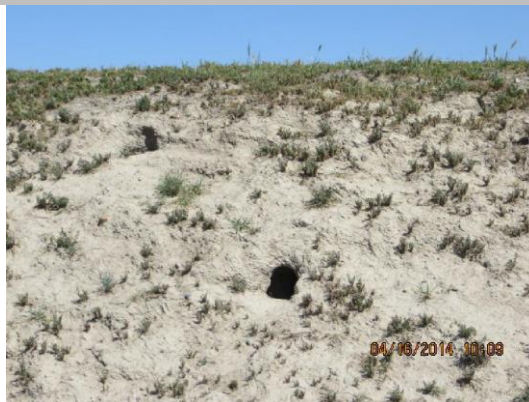
Photo 3 of 3 : UCIP\_SP\_2018\_39510\_61095.jpg

Animal burrows along alignment on LS slope.

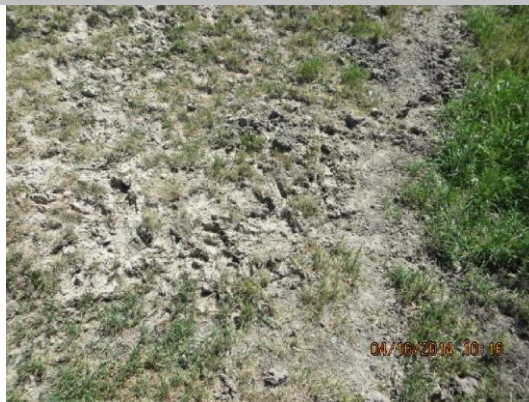
Photo 3 of 3 : UCIP\_SP\_2018\_39511\_61097.jpg

Pipe and headwall buried in sediment at LS toe.

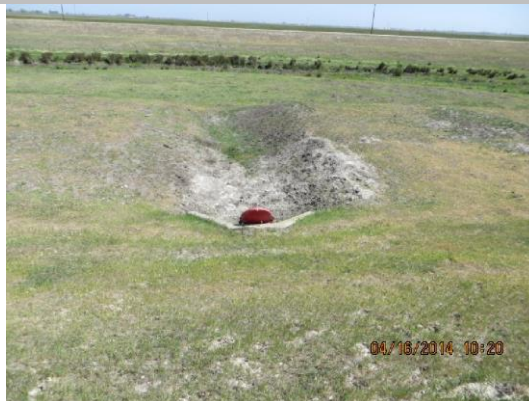
Photo 1 of 3 : UCIP\_SP\_2018\_39512\_61102.jpg

LM Start	2.12	Rating **	M	Issue No.	29
LM End	2.12	Issue Type +	Ma	Location *	
Category	Supplemental			GPS Latitude/Longitude	
				Start	End
Item	DWR UCIP LMA Responsibility			37.257800 °	37.257800 °
				-120.741604 °	-120.741604 °
DWR ID					
Comment Code					
Inspector Comment					
FS_ID:39512					
DS_ID:19836					
EP_NO: N/A					
Repair Type: Non-Urgent					
Crossing Status: Found					
UCIP Comments: Sediment buildup in pipe visible from landward side.					
FIELD_STRUCT_DESC: 24-inch corrugated metal gravity drainage pipe					
through the levee, 9.5 feet below the crown. Flap gate on the waterside					
(WS) end. Concrete headwall on each end. [Additional Reference(s):					
DWR Levee Log, 2002. USACE San Joaquin O&M Manual 601.1, 1967,					
(HLM 2.12)].					
FS Date: 4/16/2014

Pipe, headwall, and flapgate on WS toe.

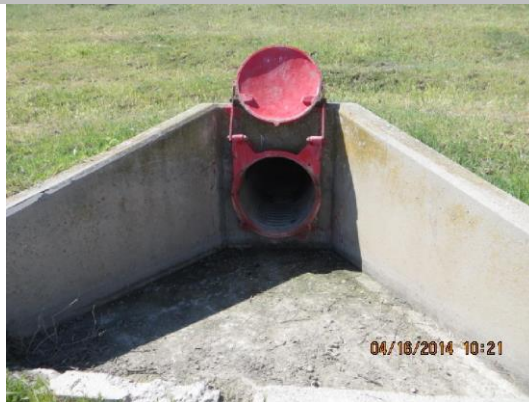
Photo 2 of 3 : UCIP\_SP\_2018\_39512\_61100.jpg

Pipe, headwall, and flapgate on WS toe.

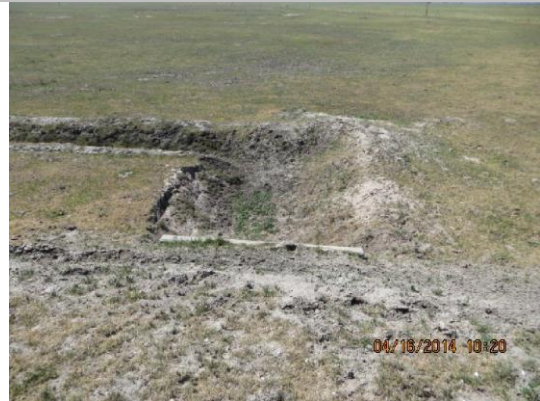
Photo 3 of 3 : UCIP\_SP\_2018\_39512\_61101.jpg

LM Start	2.12	Rating **	M	Issue No.	29 (cont)	
LM End	2.12	Issue Type +	Ma	Location *		
Category	Supplemental			GPS Latitude/Longitude		
				Start	End	
Item	DWR UCIP LMA Responsibility			37.257800 °	37.257800 °	
				-120.741604 °	-120.741604 °	
DWR ID						
Comment Code						
Inspector Comment						
FS_ID:39512						
DS_ID:19836						
EP_NO: N/A						
Repair Type: Non-Urgent						
Crossing Status: Found						
UCIP Comments: Sediment buildup in pipe visible from landward side.						
FIELD_STRUCT_DESC: 24-inch corrugated metal gravity drainage pipe						
through the levee, 9.5 feet below the crown. Flap gate on the waterside						
(WS) end. Concrete headwall on each end. [Additional Reference(s):						
DWR Levee Log, 2002. USACE San Joaquin O&M Manual 601.1, 1967,						
(HLM 2.12)].						
FS Date: 4/16/2014

Pipe and headwall on LS toe.

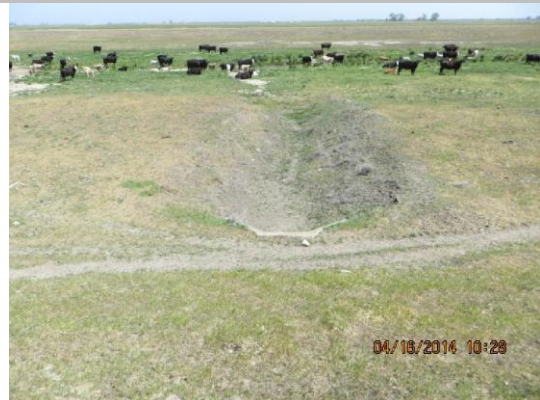
Photo 1 of 3 : UCIP\_SP\_2018\_33760\_61107.jpg

LM Start	2.77	Rating **	A/W	Issue No.	30
LM End	2.77	Issue Type +	Ma	Location *	
Category	Supplemental			GPS Latitude/Longitude	
				Start	End
Item	DWR UCIP LMA Responsibility			37.252228 °	37.252228 °
				-120.732890 °	-120.732890 °
DWR ID					
Comment Code					
Inspector Comment					
FS_ID:33760					
DS_ID:19837					
EP_NO: N/A					
Repair Type: No Action Needed					
Crossing Status: Found					
UCIP Comments:					
FIELD_STRUCT_DESC: 24-inch corrugated metal gravity drainage pipe					
through the levee, 10.5 feet below the crown. Flap gate on the					
waterside (WS) end. Concrete headwall on each end. [Additional					
Reference(s): DWR Levee Log, 2002. USACE San Joaquin O&M					
Manual 601.1, 1967, (HLM 2.77)].					
FS Date: 4/16/2014

Pipe, headwall, and flapgate on Ws toe.

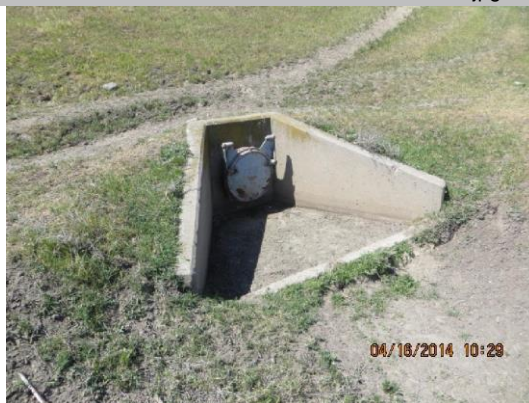
Photo 2 of 3 : UCIP\_SP\_2018\_33760\_61105.jpg

LM Start	2.77	Rating **	A/W	Issue No.	30 (cont)	
LM End	2.77	Issue Type +	Ma	Location *		
Category	Supplemental			GPS Latitude/Longitude		
				Start		End
Item	DWR UCIP LMA Responsibility			37.252228 °		37.252228 °
				-120.732890 °		-120.732890 °
DWR ID						
Comment Code						
Inspector Comment						
FS_ID:33760						
DS_ID:19837						
EP_NO: N/A						
Repair Type: No Action Needed						
Crossing Status: Found						
UCIP Comments:						
FIELD_STRUCT_DESC: 24-inch corrugated metal gravity drainage pipe						
through the levee, 10.5 feet below the crown. Flap gate on the						
waterside (WS) end. Concrete headwall on each end. [Additional						
Reference(s): DWR Levee Log, 2002. USACE San Joaquin O&M						
Manual 601.1, 1967, (HLM 2.77)].						
FS Date: 4/16/2014

Pipe, headwall, and flapgate on Ws toe.

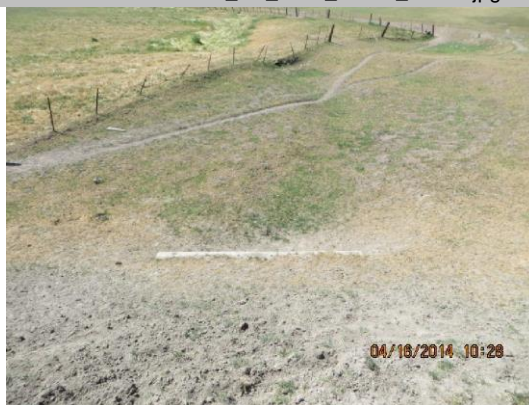
Photo 3 of 3 : UCIP\_SP\_2018\_33760\_61106.jpg

Pipe and headwall on LS toe.

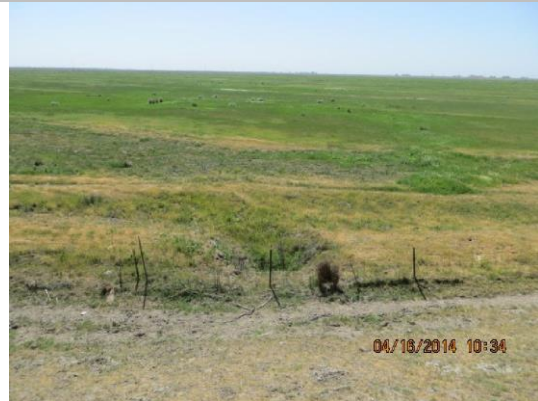
Photo 3 of 3 : UCIP\_SP\_2018\_49969\_61111.jpg

Comment Code					
Inspector Comment					
FS_ID:49969 DS_ID:19838 EP_NO: N/A Repair Type: Non-Urgent Crossing Status: Found UCIP Comments: 7/20/2016 LS inlet buried under dense vegetation. Dense vegetation limits the inspector's visibility to identify signs of pipe failure (leaks) along the WS and LS slope. Recommend removing vegetation along pipe alignment to conduct proper inspection of structure and appurtenances. (DWR UCIP - omagana)4/16/2014 Pipe blocked by silt on LS toe. Flapgate rusty and does not operate correctly. (DWR UCIP - omagana) FIELD_STRUCT_DESC: 36-inch corrugated metal gravity drainage pipe through the levee, 13.4 feet below the crown. Flap gate on the waterside (WS) end. Concrete headwall on each end. [Additional Reference(s): DWR Levee Log, 2002. USACE San Joaquin O&M Manual 601.1, 1967, (HLM 3.06)]. FS Date: 7/20/2016

Pipe and headwall on LS toe.

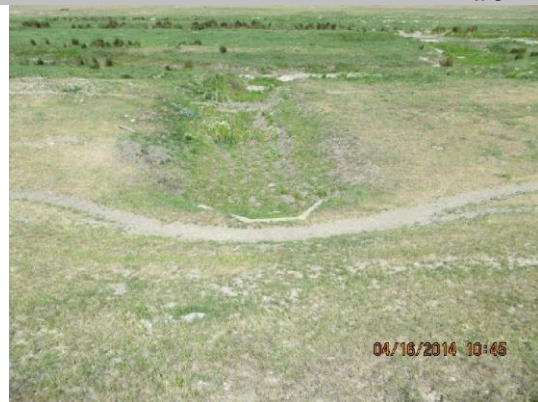
Photo 1 of 3 : UCIP\_SP\_2018\_33764\_61128.jpg

LM Start	3.24	Rating **	A/W	Issue No.	32
LM End	3.24	Issue Type +	Ma	Location *	
Category	Supplemental			GPS Latitude/Longitude	
				Start	End
Item	DWR UCIP LMA Responsibility			37.252230 °	37.252230 °
				-120.725504 °	-120.725504 °
DWR ID					
Comment Code					
Inspector Comment					
FS_ID:33764 DS_ID:19839 EP_NO: N/A Repair Type: No Action Needed Crossing Status: Found UCIP Comments: FIELD_STRUCT_DESC: 24-inch corrugated metal gravity drainage pipe through the levee, 10 feet below the crown. Flap gate on the waterside (WS) end. Concrete headwall on each end. [Additional Reference(s): DWR Levee Log, 2002. USACE San Joaquin O&M Manual 601.1, 1967, (HLM 3.24)]. FS Date: 4/16/2014

Pipe, flapgate, and headwall on WS toe.

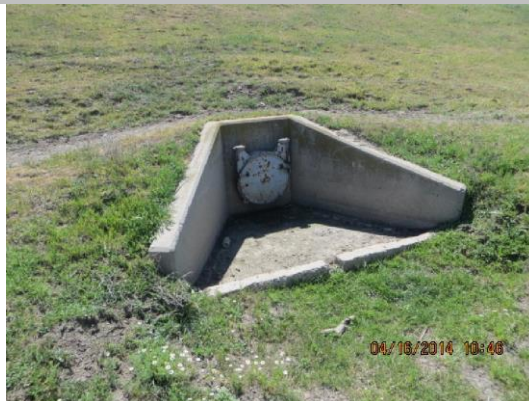
Photo 2 of 3 : UCIP\_SP\_2018\_33764\_61127.jpg

Pipe, flapgate, and headwall on WS toe.

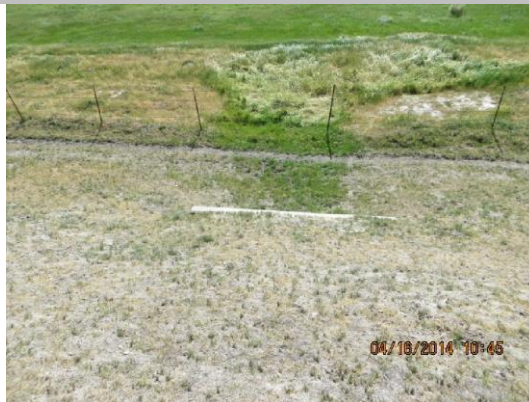
Photo 3 of 3 : UCIP\_SP\_2018\_33764\_61129.jpg

Pipe and headwall on LS toe.

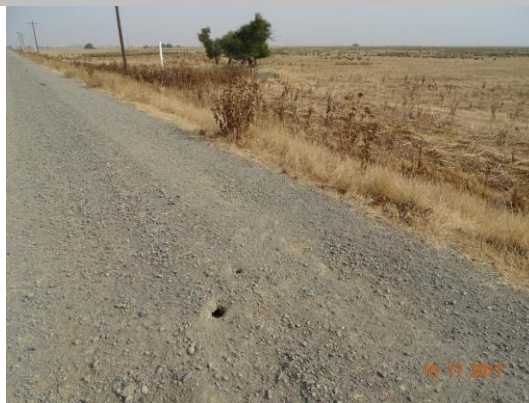
Photo 1 of 2 : SP\_2018\_NA0010\_126\_3\_20180307\_00002.jpg

LM Start	3.40	Rating **	M	Issue No.	3
LM End	3.54	Issue Type +	Ma	Location *	LS
Category	Earthen Levee			GPS Latitude/Longitude	
				Start	End
Item	Animal Control			37.253052 °	37.253600 °
				-120.722647 °	-120.720198 °
DWR ID	DWR_NA0010_08_s_2012_3				
Comment Code					
A3 : No rodents visible, but rodent burrows visible; need to backfill and compact or grout burrows.					
Inspector Comment					
Noted several rodent holes on landside slope within this reach.

Looking east at the crown towards the landside.

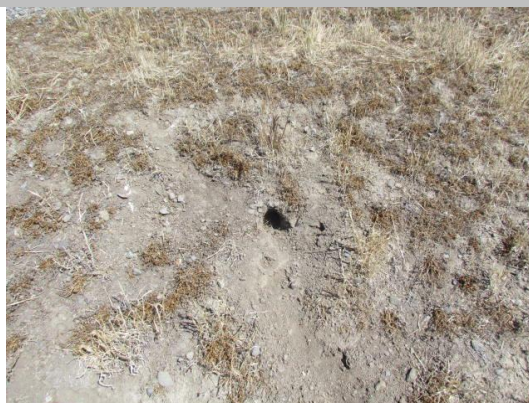
Photo 2 of 2 : SP\_2018\_NA0010\_126\_3\_20180307\_00003.jpg

Looking at typical view of rodent holes on landward slope.

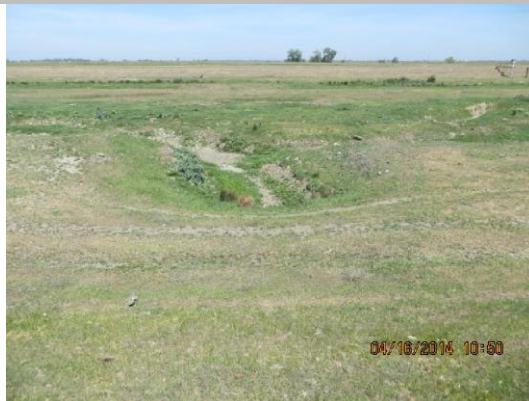
Photo 1 of 3 : UCIP\_SP\_2018\_39513\_61134.jpg

LM Start	3.43	Rating **	M	Issue No.	33
LM End	3.43	Issue Type +	Ma	Location *	
Category	Supplemental			GPS Latitude/Longitude	
				Start	End
Item	DWR UCIP LMA Responsibility			37.253151 °	37.253151 °
				-120.722182 °	-120.722182 °
DWR ID					
Comment Code					
Inspector Comment					
FS_ID:39513 DS_ID:19840 EP_NO: N/A Repair Type: Non-Urgent Crossing Status: Found UCIP Comments: No access available on landward side. Need to confirm status of crossing. FIELD_STRUCT_DESC: 24-inch corrugated metal gravity drainage pipe through the levee, 13 feet below the crown. Flap gate on the waterside (WS) end. Concrete headwall on each end. [Additional Reference(s): DWR Levee Log, 2002. USACE San Joaquin O&M Manual 601.1, 1967, (HLM 3.43)]. FS Date: 4/16/2014

Pipe, headwall, and flapgate on WS toe.

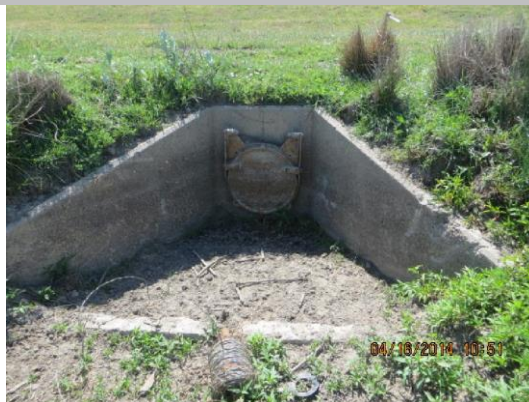
Photo 2 of 3 : UCIP\_SP\_2018\_39513\_61133.jpg

Pipe, headwall, and flapgate on WS toe.

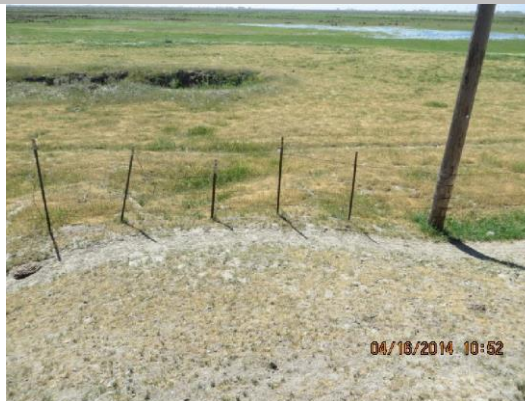
Photo 3 of 3 : UCIP\_SP\_2018\_39513\_61132.jpg

LM Start	3.43	Rating **	M	Issue No.	33 (cont)	
LM End	3.43	Issue Type +	Ma	Location *		
Category	Supplemental			GPS Latitude/Longitude		
				Start		End
Item	DWR UCIP LMA Responsibility			37.253151 °		37.253151 °
				-120.722182 °		-120.722182 °
DWR ID						
Comment Code						
Inspector Comment						
FS_ID:39513 DS_ID:19840 EP_NO: N/A Repair Type: Non-Urgent Crossing Status: Found UCIP Comments: No access available on landward side. Need to confirm status of crossing. FIELD_STRUCT_DESC: 24-inch corrugated metal gravity drainage pipe through the levee, 13 feet below the crown. Flap gate on the waterside (WS) end. Concrete headwall on each end. [Additional Reference(s): DWR Levee Log, 2002. USACE San Joaquin O&M Manual 601.1, 1967, (HLM 3.43)]. FS Date: 4/16/2014

Pipe likely at drainage swale off LS toe.

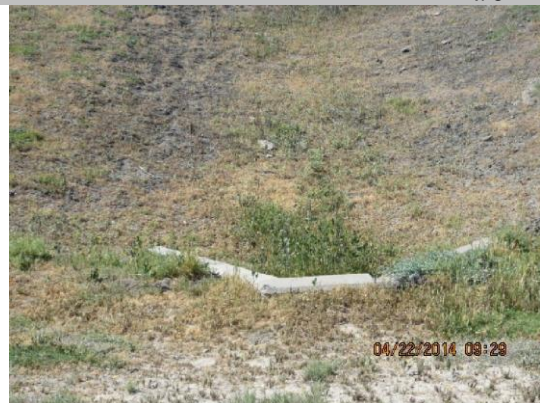
Photo 1 of 3 : UCIP\_SP\_2018\_39515\_62128.jpg

LM Start	0.69	Rating **	M	Issue No.	8
LM End	0.69	Issue Type +	Ma	Location *	
Category	Supplemental			GPS Latitude/Longitude	
				Start	End
Item	DWR UCIP LMA Responsibility			37.219874 °	37.219874 °
				-120.701438 °	-120.701438 °
DWR ID					
Comment Code					
Inspector Comment					
FS_ID:39515 DS_ID:19842 EP_NO: N/A Repair Type: Non-Urgent Crossing Status: Found UCIP Comments: Animal burrows in area on LS slope. Minor sediment buildup in pipe visible on landward side--recommend clearing. FIELD_STRUCT_DESC: 24-inch corrugated metal gravity drainage pipe through the levee, 8.7 feet below the crown. Flap gate on the waterside (WS) end. Concrete headwall on the landside (LS) end. Concrete U-shaped headwall on the WS end. [Additional Reference(s): DWR Levee Log, 2002. USACE San Joaquin O&M Manual 601.1, 1967, (HLM 0.70)]. FS Date: 4/22/2014

Headwall, flapgate, and pipe on WS toe.

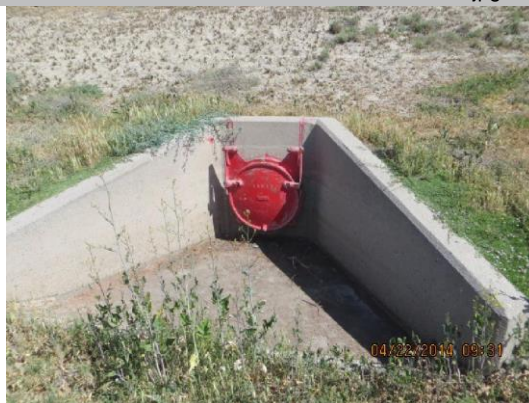
Photo 2 of 3 : UCIP\_SP\_2018\_39515\_62132.jpg

Comment Code						
Inspector Comment						
FS_ID:39515						
DS_ID:19842						
EP_NO: N/A						
Repair Type: Non-Urgent						
Crossing Status: Found						
UCIP Comments: Animal burrows in area on LS slope. Minor sediment buildup in pipe visible on landward side--recommend clearing.						
FIELD_STRUCT_DESC: 24-inch corrugated metal gravity drainage pipe through the levee, 8.7 feet below the crown. Flap gate on the waterside (WS) end. Concrete headwall on the landside (LS) end. Concrete U-shaped headwall on the WS end. [Additional Reference(s): DWR Levee Log, 2002. USACE San Joaquin O&M Manual 601.1, 1967, (HLM 0.70)].						
FS Date: 4/22/2014

Headwall, flapgate, and pipe on WS toe.

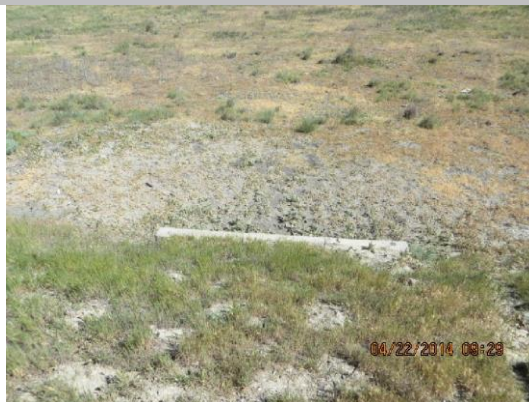
Photo 3 of 3 : UCIP\_SP\_2018\_39515\_62129.jpg

Headwall and pipe on LS toe.

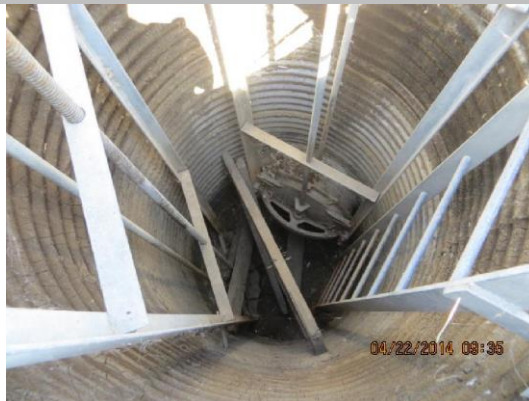
Photo 2 of 3 : UCIP\_SP\_2018\_34186\_62133.jpg

LM Start	0.87	Rating **	A/W	Issue No.	9 (cont)	
LM End	0.87	Issue Type +	Ma	Location *		
Category	Supplemental			GPS Latitude/Longitude		
				Start	End	
Item	DWR UCIP LMA Responsibility			37.220051 °	37.220051 °	
				-120.698374 °	-120.698374 °	
DWR ID						
Comment Code						
Inspector Comment						
FS_ID:34186 DS_ID:19843 EP_NO: N/A Repair Type: No Action Needed Crossing Status: Found UCIP Comments: FIELD_STRUCT_DESC: 24-inch corrugated metal gravity drainage pipe through the levee, 9.7 feet below the crown. Two slide gates in a 48-inch corrugated metal pipe (CMP) riser on the waterside (WS) slope. Concrete U-shaped headwall on the landside (LS) end. WS end cobble revetted on the bank and in the outlet drain. [Additional Reference(s): DWR Levee Log, 2002. USACE San Joaquin O&M Manual 601.1, 1967, (HLM 0.87)]. FS Date: 4/22/2014

Inside CMP riser on WS slope.

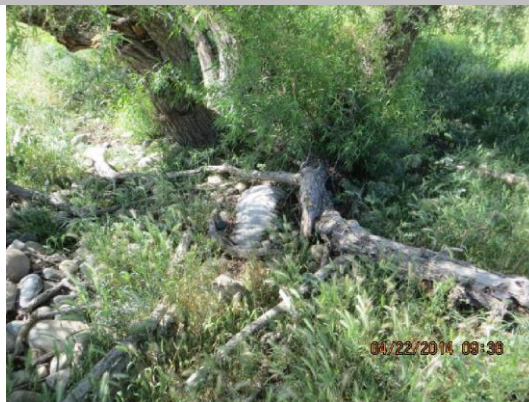
Photo 3 of 3 : UCIP\_SP\_2018\_34186\_62137.jpg

Outlet at WS toe.

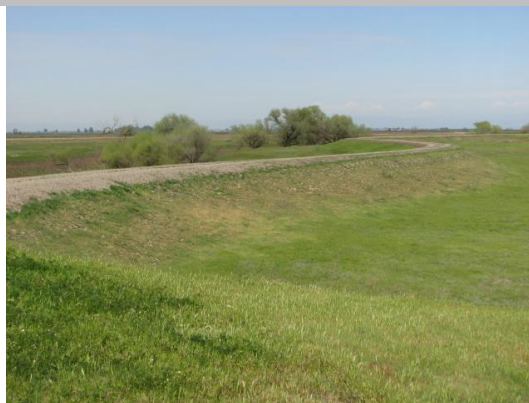
Photo 1 of 1 : SP\_2018\_NA0010\_128\_3\_20180411\_00005.jpg

LM Start	0.00	Rating **	M	Issue No.	3
LM End	0.78	Issue Type +	Ma	Location *	LS
Category	Earthen Levee			GPS Latitude/Longitude	
				Start	End
Item	Vegetation			37.217893 °	37.219331 °
				-120.711456 °	-120.698171 °
DWR ID	DWR_NA0010_10_s _ 2018_3				
Comment Code					
V1 : Control annual grass and weeds on the levee slopes and easements.					
Inspector Comment					
LMA to maintain vegetation on LS slope.

Looking upstream at typical view of landward slope. (Spring 2018)

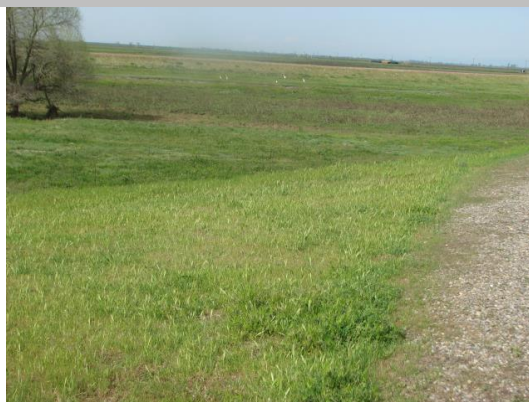
Photo 1 of 1 : SP\_2018\_NA0010\_128\_4\_20180411\_00006.jpg

LM Start	0.00	Rating **	M	Issue No.	4
LM End	0.78	Issue Type +	Ma	Location *	WS
Category	Earthen Levee			GPS Latitude/Longitude	
				Start	End
Item	Vegetation			37.217893 °	37.219335 °
				-120.711456 °	-120.698172 °
DWR ID	DWR_NA0010_10_s _ 2018_4				
Comment Code					
V1 : Control annual grass and weeds on the levee slopes and easements.					
Inspector Comment					
LMA to maintain vegetation on WS slope.

Looking northeast at typical view of waterward slope. (Spring 2018)

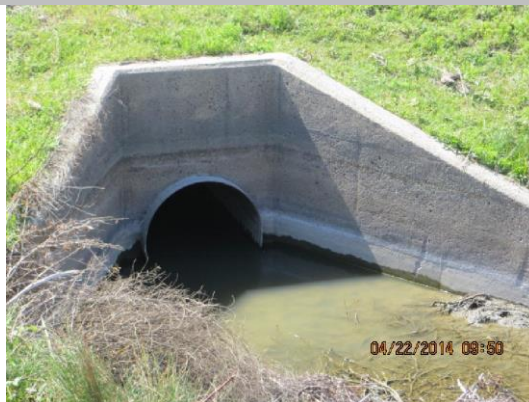
Photo 2 of 3 : UCIP\_SP\_2018\_39516\_62146.jpg

Headwall and pipe on WS toe.

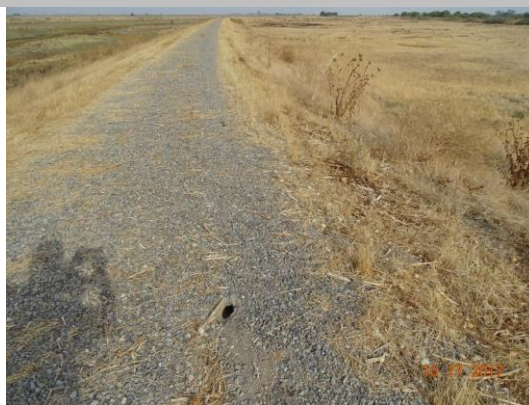
Photo 1 of 1 : SP\_2018\_NA0010\_128\_2\_20180307\_00001.jpg

LM Start	0.32	Rating **	A/W	Issue No.	2
LM End	0.32	Issue Type +	Ma	Location *	CR
Category	Earthen Levee			GPS Latitude/Longitude	
				Start	End
Item	Animal Control			37.219192 °	37.219192 °
				-120.706295 °	-120.706295 °
DWR ID	DWR_NA0010_10_f_2017_2				
Comment Code					
A1 : Exterminate rodents and backfill and compact or grout burrows.					
Inspector Comment

Looking west at the crown.

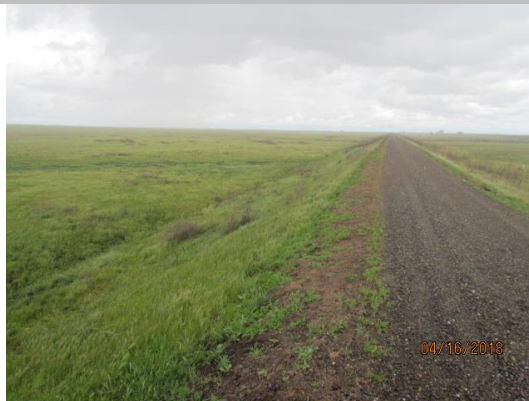
Photo 1 of 1 : SP\_2018\_NA0010\_129\_10\_20180420\_00024.jpg

LM Start	0.00	Rating **	M	Issue No.	10
LM End	3.31	Issue Type +	Ma	Location *	LS
Category	Earthen Levee			GPS Latitude/Longitude	
				Start	End
Item	Vegetation			37.202749 °	37.202321 °
				-120.755184 °	-120.695304 °
DWR ID	DWR_NA0010_11_s_2018_10				
Comment Code					
V1 : Control annual grass and weeds on the levee slopes and easements.					
Inspector Comment

Looking south at typical view of landward slope. (Spring 2018)

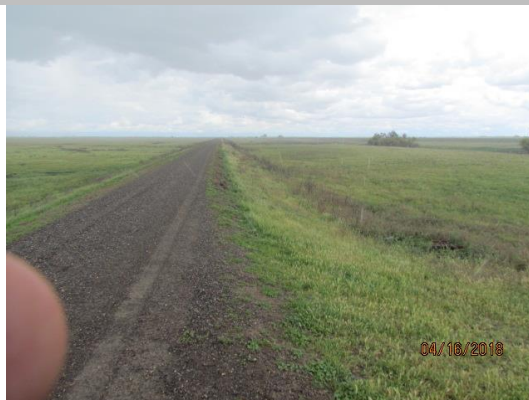
Photo 1 of 1 : SP\_2018\_NA0010\_129\_11\_20180420\_00023.jpg

LM Start	0.00	Rating **	M	Issue No.	11
LM End	3.31	Issue Type +	Ma	Location *	WS
Category	Earthen Levee			GPS Latitude/Longitude	
				Start	End
Item	Vegetation			37.202749 °	37.202321 °
				-120.755184 °	-120.695304 °
DWR ID	DWR_NA0010_11_s_2018_11				
Comment Code					
V1 : Control annual grass and weeds on the levee slopes and easements.					
Inspector Comment

Looking south at typical view of waterward slope. (Spring 2018)

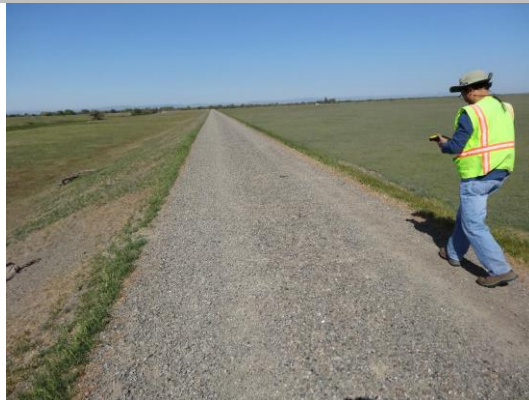
Photo 2 of 3 : UCIP\_SP\_2018\_39517\_66643.jpg

View of levee crown at crossing.

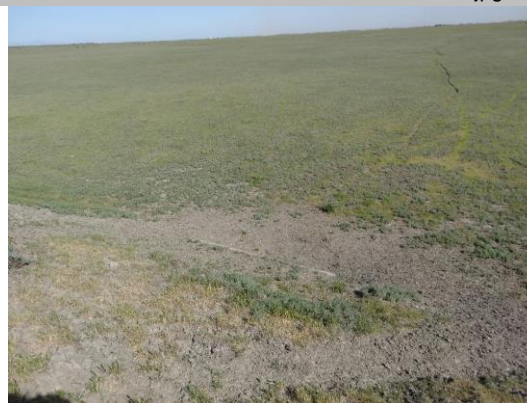
Photo 3 of 3 : UCIP\_SP\_2018\_39517\_66642.jpg

View of landward side.

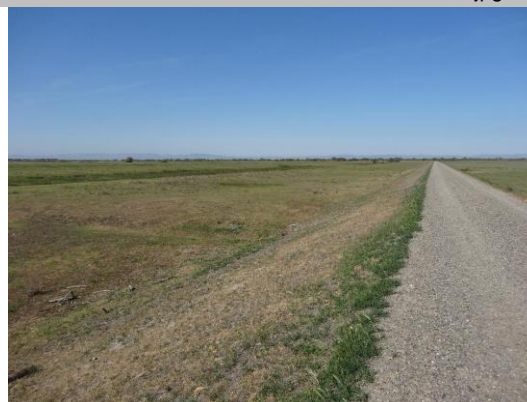
Photo 1 of 3 : UCIP\_SP\_2018\_39518\_61997.jpg

LM Start	0.65	Rating **	M	Issue No.	13
LM End	0.65	Issue Type +	Ma	Location *	
Category	Supplemental			GPS Latitude/Longitude	
				Start	End
Item	DWR UCIP LMA Responsibility			37.202751 °	37.202751 °
				-120.743474 °	-120.743474 °
DWR ID					
Comment Code					
Inspector Comment					
FS_ID:39518					
DS_ID:19847					
EP_NO: N/A					
Repair Type: Non-Urgent					
Crossing Status: Found					
UCIP Comments: Need to contact owner. Recommend clearing sediment deposit inside pipe.					
FIELD_STRUCT_DESC: 24-inch corrugated metal gravity drainage pipe through the levee, 10 feet below the crown. Flap gate on the waterside (WS) end. [Additional Reference(s): DWR Levee Log, 2002. USACE San Joaquin O&M Manual 601.1, 1967, (HLM 0.65)].					
FS Date: 4/18/2014

View of waterward side.

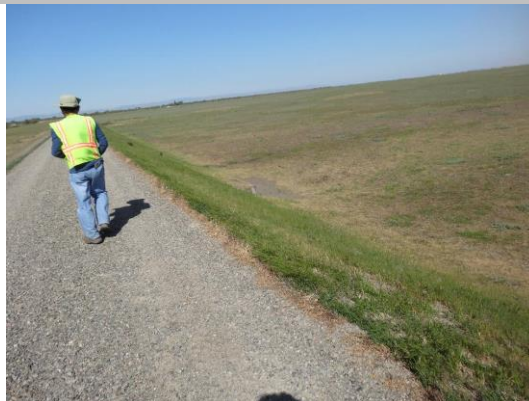
Photo 2 of 3 : UCIP\_SP\_2018\_39518\_61996.jpg

View of landward side.

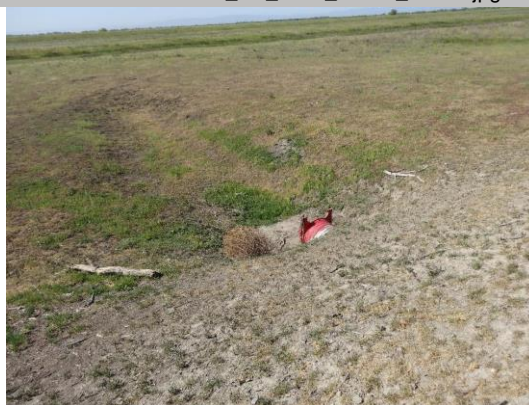
Photo 3 of 3 : UCIP\_SP\_2018\_39518\_61999.jpg

Flap gate and concrete apron located on waterward side.

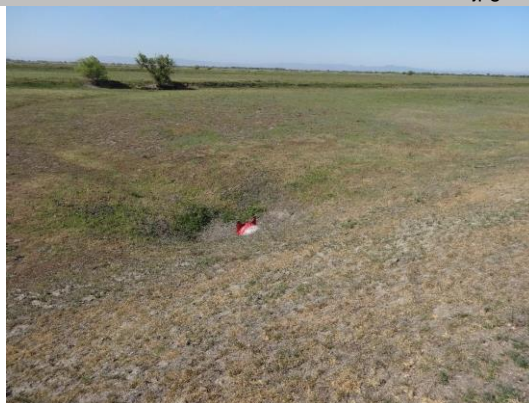
Photo 1 of 3 : UCIP\_SP\_2018\_39519\_62003.jpg

LM Start	0.84	Rating **	M	Issue No.	14
LM End	0.84	Issue Type +	Ma	Location *	
Category	Supplemental			GPS Latitude/Longitude	
				Start	End
Item	DWR UCIP LMA Responsibility			37.202745 °	37.202745 °
				-120.739935 °	-120.739935 °
DWR ID					
Comment Code					
Inspector Comment					
FS_ID:39519 DS_ID:19848 EP_NO: N/A Repair Type: Non-Urgent Crossing Status: Found UCIP Comments: Need to contact owner. Recommend clearing sediment deposit inside pipe. FIELD_STRUCT_DESC: 24-inch corrugated metal gravity drainage pipe through the levee, 10.3 feet below the crown. Flap gate on the waterside (WS) end. [Additional Reference(s): DWR Levee Log, 2002. USACE San Joaquin O&M Manual 601.1, 1967, (HLM 0.84)]. FS Date: 4/18/2014

Overview of waterward side.

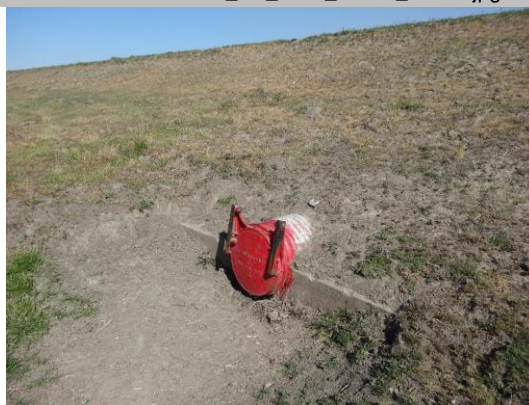
Photo 2 of 3 : UCIP\_SP\_2018\_39519\_62002.jpg

Concrete headwall and flap gate visible on waterward side.

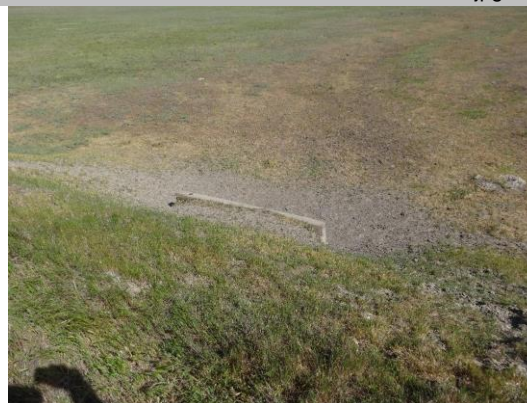
Photo 3 of 3 : UCIP\_SP\_2018\_39519\_62001.jpg

View of landward side.

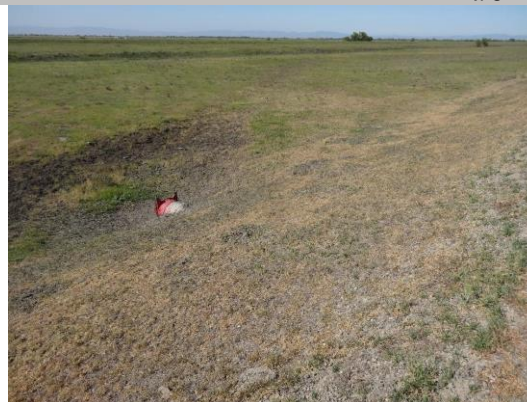
Photo 1 of 3 : UCIP\_SP\_2018\_39520\_62008.jpg

LM Start	1.13	Rating **	M	Issue No.	15	
LM End	1.13	Issue Type +	Ma	Location *		
Category	Supplemental			GPS Latitude/Longitude		
				Start		End
Item	DWR UCIP LMA Responsibility			37.202748 °		37.202748 °
				-120.734796 °		-120.734796 °
DWR ID						
Comment Code						
Inspector Comment						
FS_ID:39520 DS_ID:19849 EP_NO: N/A Repair Type: Non-Urgent Crossing Status: Found UCIP Comments: Need to contact owner. Recommend clearing sediment deposit inside pipe. FIELD_STRUCT_DESC: 24-inch corrugated metal gravity drainage pipe through the levee, 9 feet below the crown. Flap gate on the waterside (WS) end. [Additional Reference(s): DWR Levee Log, 2002. USACE San Joaquin O&M Manual 601.1, 1967, (HLM 1.13)]. FS Date: 4/18/2014

View of waterward side--flap gate visible at levee toe.

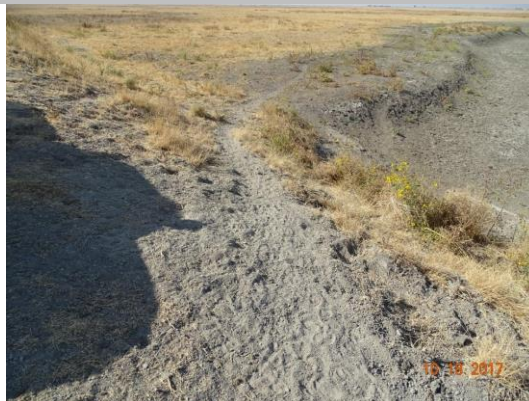
Photo 1 of 1 : SP\_2018\_NA0010\_129\_9\_20180307\_00001.jpg

LM Start	1.49	Rating **	M	Issue No.	9
LM End	1.49	Issue Type +	Ma	Location *	LS
Category	Earthen Levee			GPS Latitude/Longitude	
				Start	End
Item	Slope Stability			37.202748 °	37.202748 °
				-120.728182 °	-120.728182 °
DWR ID	DWR_NA0010_11_f_2017_9				
Comment Code					
S2 : Repair the levee slope damaged by foot traffic and prevent access where possible.					
Inspector Comment

Looking northwest at landside slope.

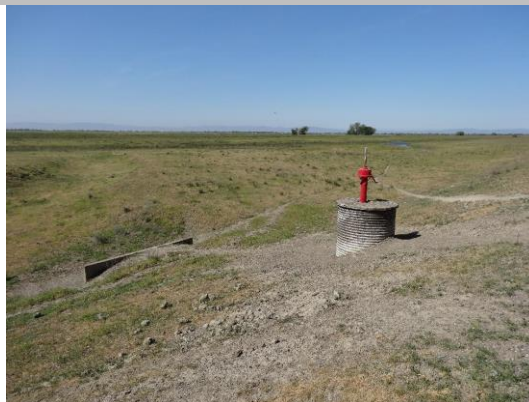
Photo 1 of 3 : UCIP\_SP\_2018\_39521\_62018.jpg

LM Start	1.49	Rating **	M	Issue No.	16
LM End	1.49	Issue Type +	Ma	Location *	
Category	Supplemental			GPS Latitude/Longitude	
				Start	End
Item	DWR UCIP LMA Responsibility			37.202753 °	37.202753 °
				-120.728133 °	-120.728133 °
DWR ID					
Comment Code					
Inspector Comment					
FS_ID:39521 DS_ID:19850 EP_NO: N/A Repair Type: Non-Urgent Crossing Status: Found UCIP Comments: Need to contact owner. Recommend clearing sediment deposit inside pipe. FIELD_STRUCT_DESC: 48-inch corrugated metal gravity drainage pipe through the levee, 16.3 feet below the crown. Slide gate in a pipe riser on the waterside (WS) slope. [Additional Reference(s): DWR Levee Log, 2002. USACE San Joaquin O&M Manual 601.1, 1967, (HLM 1.50)]. FS Date: 4/18/2014

View of waterward side.

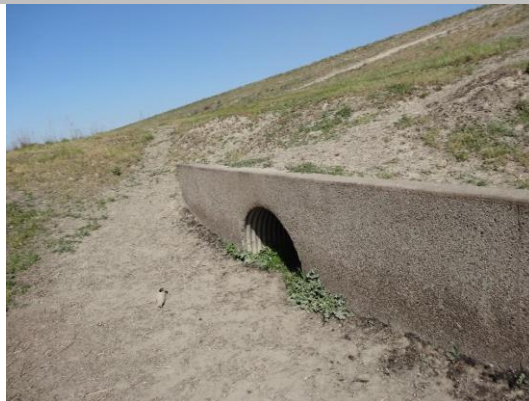
Photo 2 of 3 : UCIP\_SP\_2018\_39521\_62017.jpg

View of concrete headwall located on waterward side.

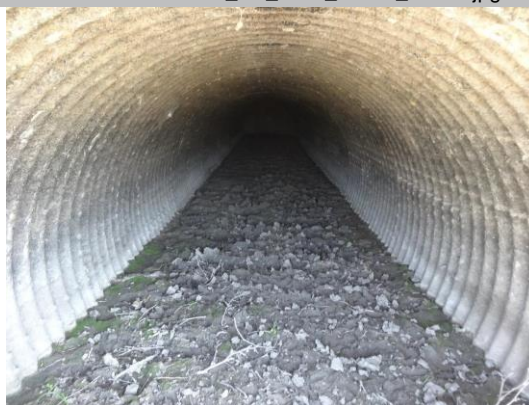
Photo 3 of 3 : UCIP\_SP\_2018\_39521\_62016.jpg

Inside view of pipe from waterward side--sediment build up.
