**Flood Control Project Maintenance  
Levee Inspections**

## Maintenance Issue Types Only, Levee Inspection Report By Mile - Spring 2018

### Lower San Joaquin Levee District

Waterway	Bank	Unit Miles	Inspection Start/End	Inspector
Unit No. 01 San Joaquin River	Right	22.52	04/04/2018 04/16/2018	Richard Willoughby

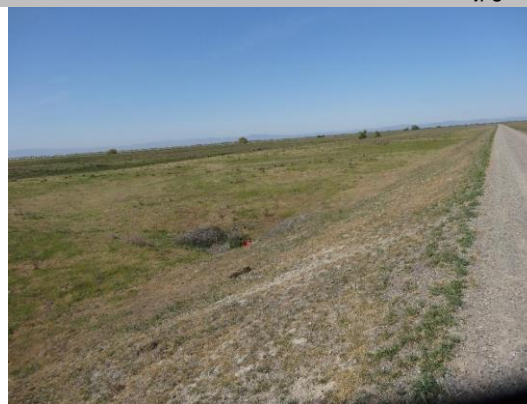
Photo 1 of 3 : UCIP\_SP\_2018\_39522\_62024.jpg

LM Start	1.98	Rating **	M	Issue No.	17
LM End	1.98	Issue Type +	Ma	Location *	
Category	Supplemental			GPS Latitude/Longitude	
				Start	End
Item	DWR UCIP LMA Responsibility			37.202740 °	37.202740 °
				-120.719247 °	-120.719247 °
DWR ID					
Comment Code					
Inspector Comment					
FS_ID:39522					
DS_ID:19851					
EP_NO: N/A					
Repair Type: Non-Urgent					
Crossing Status: Found					
UCIP Comments: Need to contact owner. Recommend clearing sediment deposit inside pipe.					
FIELD_STRUCT_DESC: 24-inch corrugated metal gravity drainage pipe through the levee, 12.8 feet below the crown. Flap gate on the waterside (WS) end. [Additional Reference(s): DWR Levee Log, 2002. USACE San Joaquin O&M Manual 601.1, 1967, (HLM 1.99)].					
FS Date: 4/18/2014

View of waterward side.

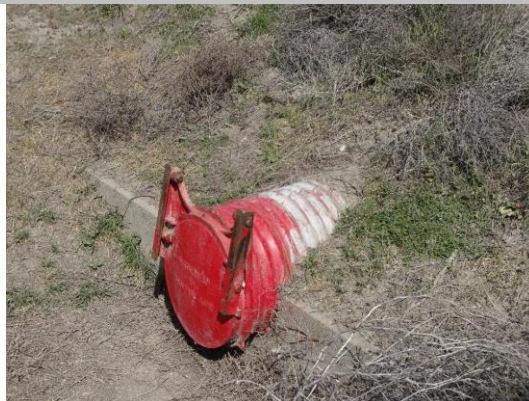
Photo 2 of 3 : UCIP\_SP\_2018\_39522\_62025.jpg

Flap gate located on waterward side.

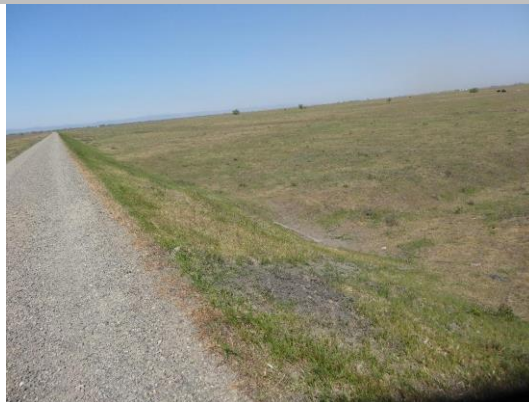
Photo 3 of 3 : UCIP\_SP\_2018\_39522\_62023.jpg

View of landward side.

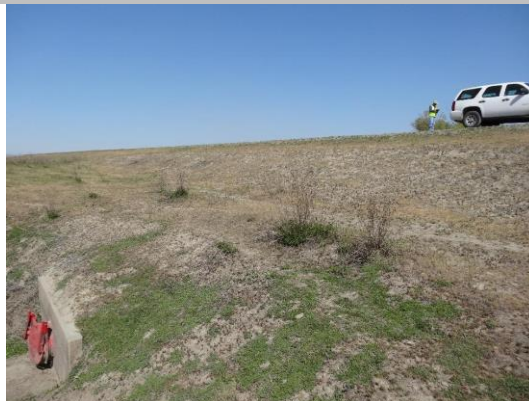
Photo 1 of 3 : UCIP\_SP\_2018\_39523\_62028.jpg

LM Start	3.04	Rating **	M	Issue No.	18
LM End	3.04	Issue Type +	Ma	Location *	
Category	Supplemental			GPS Latitude/Longitude	
				Start	End
Item	DWR UCIP LMA Responsibility			37.202494 °	37.202494 °
				-120.700153 °	-120.700153 °
DWR ID					
Comment Code					
Inspector Comment					
FS_ID:39523 DS_ID:19852 EP_NO: N/A Repair Type: Non-Urgent Crossing Status: Found UCIP Comments: Need to contact owner. Recommend clearing sediment deposit inside pipe. FIELD_STRUCT_DESC: 24-inch corrugated metal gravity drainage pipe through the levee, 15 feet below the crown. Flap gate on the waterside (WS) end. [Additional Reference(s): DWR Levee Log, 2002. USACE San Joaquin O&M Manual 601.1, 1967, (HLM 3.04)]. FS Date: 4/18/2014

Overview of waterward side--flap gate, concrete headwall and apron visible on levee toe.

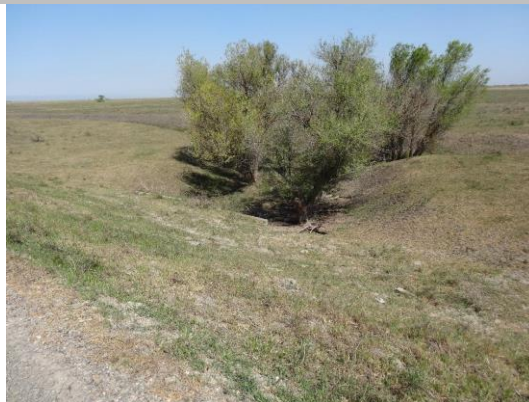
Photo 2 of 3 : UCIP\_SP\_2018\_39523\_62027.jpg

View of landward side.

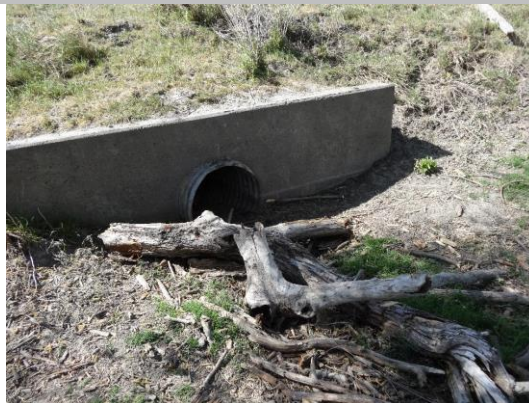
Photo 3 of 3 : UCIP\_SP\_2018\_39523\_62030.jpg

Concrete headwall located on landward side--debris in front of headwall.

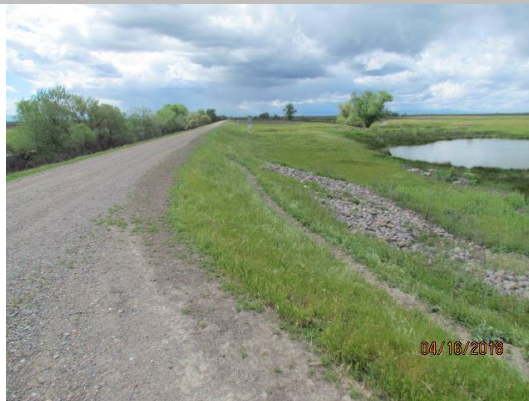
Photo 1 of 1 : SP\_2018\_NA0010\_130\_12\_20180420\_00025.jpg

LM Start	0.00	Rating **	M	Issue No.	12
LM End	3.33	Issue Type +	Ma	Location *	WS
Category	Earthen Levee			GPS Latitude/Longitude	
				Start	End
Item	Vegetation			37.200959 °	37.200979 °
				-120.755286 °	-120.694899 °
DWR ID	DWR_NA0010_12_s_2018_12				
Comment Code					
V1 : Control annual grass and weeds on the levee slopes and easements.					
Inspector Comment

Looking south at typical view of waterward slope. (Spring 2018)

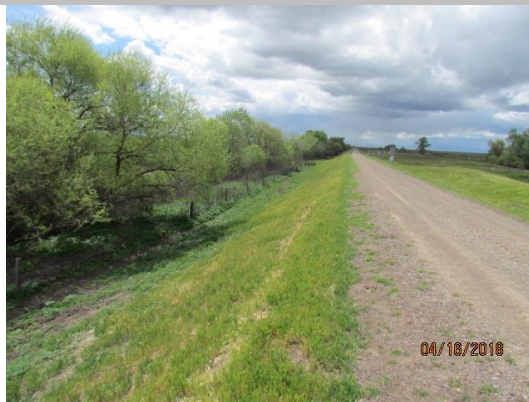
Photo 1 of 1 : SP\_2018\_NA0010\_130\_11\_20180420\_00026.jpg

LM Start	0.00	Rating **	M	Issue No.	11
LM End	3.33	Issue Type +	Ma	Location *	LS
Category	Earthen Levee			GPS Latitude/Longitude	
				Start	End
Item	Vegetation			37.200959 °	37.200981 °
				-120.755286 °	-120.694899 °
DWR ID	DWR_NA0010_12_s_2018_11				
Comment Code					
V1 : Control annual grass and weeds on the levee slopes and easements.					
Inspector Comment

Looking south at typical view of landward slope. (Spring 2018)

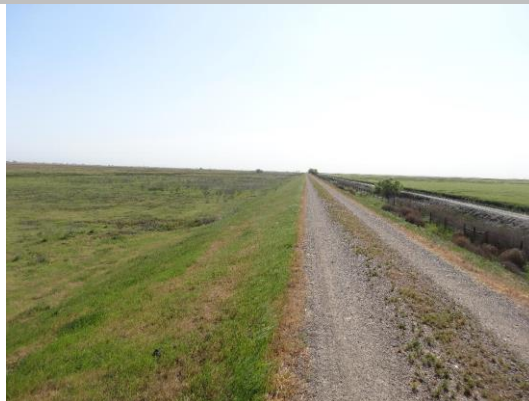
Photo 1 of 3 : UCIP\_SP\_2018\_36704\_66647.jpg

LM Start	0.40	Rating **	M	Issue No.	14
LM End	0.40	Issue Type +	Ma	Location *	
Category	Supplemental			GPS Latitude/Longitude	
				Start	End
Item	DWR UCIP LMA Responsibility			37.200934 °	37.200934 °
				-120.747996 °	-120.747996 °
DWR ID					
Comment Code					
Inspector Comment					
FS_ID:36704 DS_ID:19855 EP_NO: N/A Repair Type: Non-Urgent Crossing Status: Found UCIP Comments: Need to contact owner. Dense vegetation limits the inspector's visibility to identify signs of pipe failure (leaks) along the waterward slope. Recommend removing vegetation along pipe alignment to conduct proper inspection of structure. FIELD_STRUCT_DESC: 24-inch corrugated metal gravity drainage pipe through the levee, 10.5 feet below the crown. Flap gate on the waterside (WS) end. [Additional Reference(s): DWR Levee Log, 2002. USACE San Joaquin O&M Manual 601.1, 1967, (HLM 0.39)]. FS Date: 4/18/2014

View of waterward side.

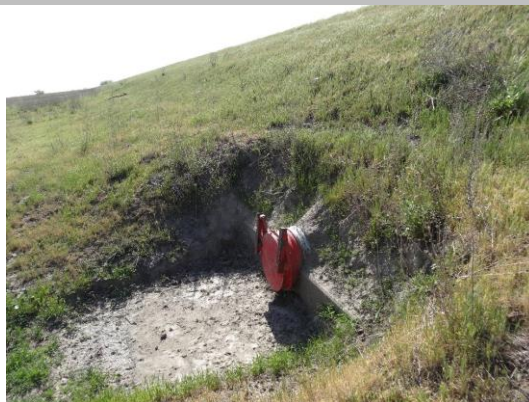
Photo 2 of 3 : UCIP\_SP\_2018\_36704\_66649.jpg

Concrete headwall and flap gate visible on waterward side.

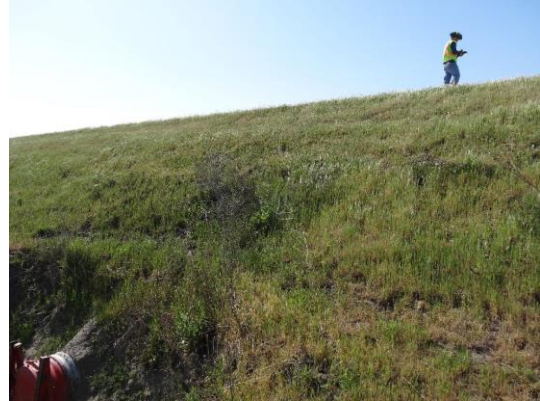
Photo 3 of 3 : UCIP\_SP\_2018\_36704\_66648.jpg

Comment Code						
Inspector Comment						
FS_ID:36704 DS_ID:19855 EP_NO: N/A Repair Type: Non-Urgent Crossing Status: Found UCIP Comments: Need to contact owner. Dense vegetation limits the inspector's visibility to identify signs of pipe failure (leaks) along the waterward slope. Recommend removing vegetation along pipe alignment to conduct proper inspection of structure. FIELD_STRUCT_DESC: 24-inch corrugated metal gravity drainage pipe through the levee, 10.5 feet below the crown. Flap gate on the waterside (WS) end. [Additional Reference(s): DWR Levee Log, 2002. USACE San Joaquin O&M Manual 601.1, 1967, (HLM 0.39)]. FS Date: 4/18/2014

View of waterward side--medium grass throughout slope.

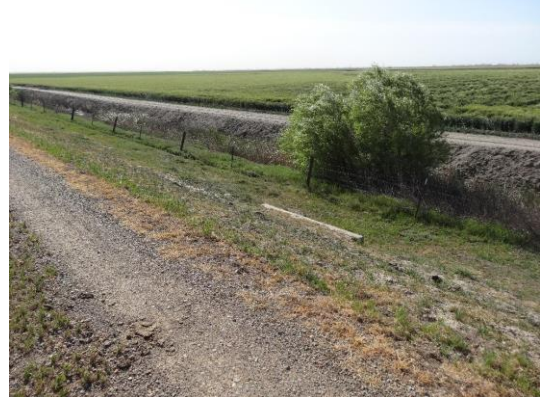
Photo 3 of 3 : UCIP\_SP\_2018\_39889\_62047.jpg

LM Start	1.06	Rating **	M	Issue No.	15 (cont)	
LM End	1.06	Issue Type +	Ma	Location *		
Category	Supplemental			GPS Latitude/Longitude		
				Start	End	
Item	DWR UCIP LMA Responsibility			37.200922 °	37.200922 °	
				-120.736012 °	-120.736012 °	
DWR ID						
Comment Code						
Inspector Comment						
FS_ID:39889						
DS_ID:19856						
EP_NO: N/A						
Repair Type: Non-Urgent						
Crossing Status: Found						
UCIP Comments: Need to contact owner. Recommend clearing sediment deposit inside pipe.						
FIELD_STRUCT_DESC: 24-inch corrugated metal gravity drainage pipe through the levee, 10.5 feet below the crown. Flap gate on the waterside (WS) end. [Additional Reference(s): DWR Levee Log, 2002. USACE San Joaquin O&M Manual 601.1, 1967, (HLM 1.06)].						
FS Date: 4/18/2014

View of landward side.

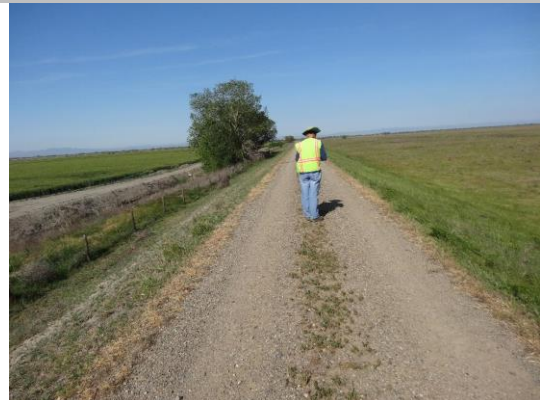
Photo 1 of 3 : UCIP\_SP\_2018\_36705\_66654.jpg

Comment Code						
Inspector Comment						
FS_ID:36705						
DS_ID:19857						
EP_NO: N/A						
Repair Type: Non-Urgent						
Crossing Status: Found						
UCIP Comments: Landward side not accessible due to dense vegetation and fence. Concrete headwall and flap gate under water therefore not able to evaluate condition. Will need to coordinate with owner to evaluate condition of crossing on waterward side and obtain access to evaluate landward side.						
FIELD_STRUCT_DESC: 24-inch corrugated metal gravity drainage pipe through the levee, 17.4 feet below the crown. Flap gate on the waterside (WS) end. [Additional Reference(s): DWR Levee Log, 2002. USACE San Joaquin O&M Manual 601.1, 1967, (HLM 1.27)].						
FS Date: 4/18/2014

Overview of levee crown at crossing.

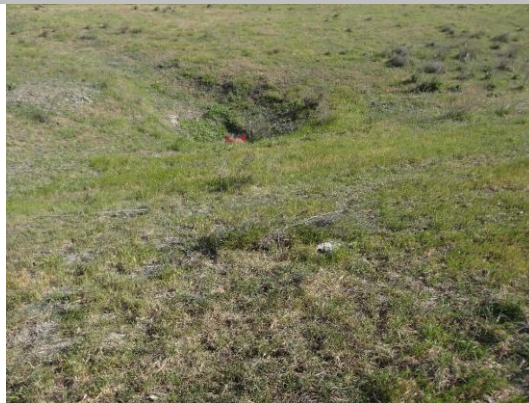
Photo 1 of 3 : UCIP\_SP\_2018\_34126\_62060.jpg

FS\_ID:34126  
DS\_ID:19858  
EP\_NO: N/A  
Repair Type: Non-Urgent  
Crossing Status: Found  
UCIP Comments: Limited access on landward side due to fence and dense vegetation. Recommend obtaining access to landward side and clear vegetation on landward side.  
FIELD\_STRUCT\_DESC: 24-inch corrugated metal gravity drainage pipe through the levee, 10.7 feet below the crown. Flap gate on the waterside (WS) end. [Additional Reference(s): DWR Levee Log, 2002. USACE San Joaquin O&M Manual 601.1, 1967, (HLM 1.53)].  
FS Date: 4/18/2014

View of waterward side.

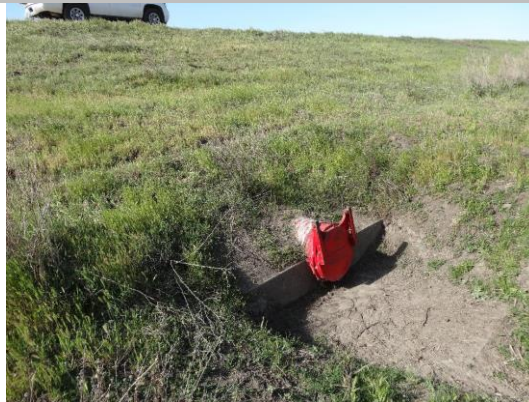
Photo 2 of 3 : UCIP\_SP\_2018\_34126\_62061.jpg

Concrete headwall and flap gate visible on waterward side.

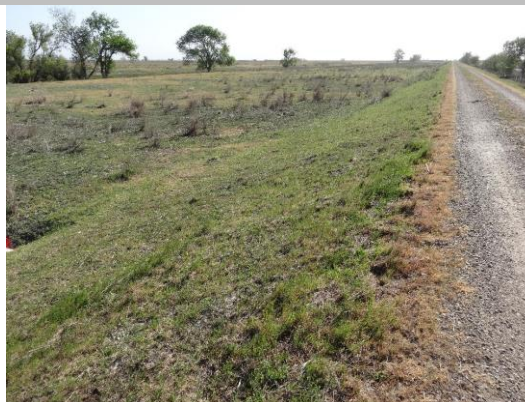
Photo 1 of 3 : UCIP\_SP\_2018\_39890\_62069.jpg

LM Start	2.70	Rating **	M	Issue No.	19
LM End	2.70	Issue Type +	Ma	Location *	
Category	Supplemental			GPS Latitude/Longitude	
				Start	End
Item	DWR UCIP LMA Responsibility			37.200906 °	37.200906 °
				-120.706316 °	-120.706316 °
DWR ID					
Comment Code					
Inspector Comment					
FS_ID:39890					
DS_ID:19860					
EP_NO: N/A					
Repair Type: Non-Urgent					
Crossing Status: Found					
UCIP Comments: Need to contact owner. Recommend clearing sediment deposit inside pipe.					
FIELD_STRUCT_DESC: 24-inch corrugated metal gravity drainage pipe through the levee, 10.7 feet below the crown. Flap gate on the waterside (WS) end. [Additional Reference(s): DWR Levee Log, 2002. USACE San Joaquin O&M Manual 601.1, 1967, (HLM 2.70)].					
FS Date: 4/18/2014

View of waterward side.

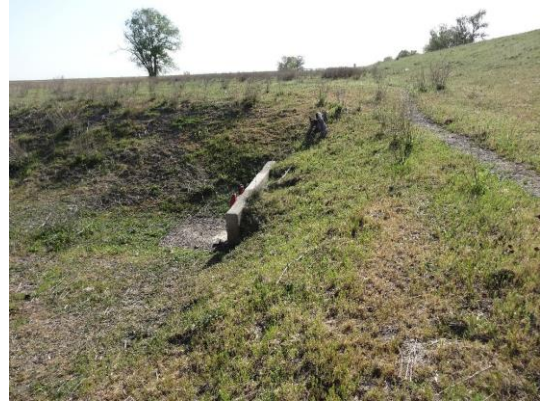
Photo 3 of 3 : UCIP\_SP\_2018\_46786\_62072.jpg

Comment Code						
Inspector Comment						
FS_ID:46786 DS_ID:19861 EP_NO: N/A Repair Type: Non-Urgent Crossing Status: Found UCIP Comments: 11-09-2015 DWR Inspection section confirmed issue has been addressed. Need to coordinate with LMA to determine additional details for extent of repair. 10-18-2014 Soil missing behind concrete headwall on waterward side. Unable to determine if missing soil is due to sink holes, rodent activity, or due to erosion. Headwall appears to be leaning slightly forward. Reason why this crossing was labelled urgent was due to the uncertainty of damage to concrete headwall and reason for soil missing behind concrete. Need to coordinate with LMA to determine more information about repair at this location. FIELD_STRUCT_DESC: 24-inch corrugated metal gravity drainage pipe through the levee, 2 feet below the crown. Flap gate on the waterside (WS) end. [Additional Reference(s): DWR Levee Log, 2002. USACE San Joaquin O&M Manual 601.1, 1967, (HLM 3.00)]. FS Date: 11/10/2015 9:29:00 AM

Side view of concrete headwall which appears to be slightly slanted forward--missing soil behind headwall.

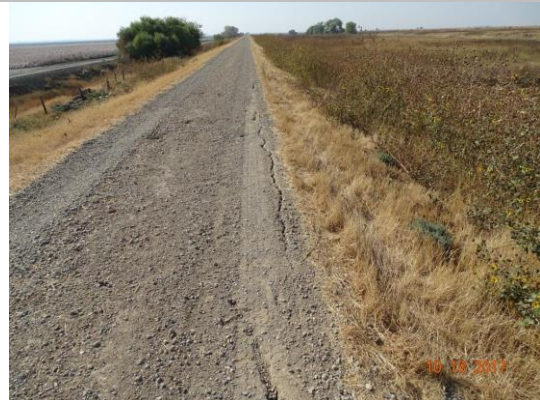
Photo 1 of 3 : SP\_2018\_NA0010\_130\_10\_20180307\_00001.jpg

LM Start	3.00	Rating **	M	Issue No.	10
LM End	3.02	Issue Type +	Ma	Location *	CR
Category	Earthen Levee			GPS Latitude/Longitude	
				Start	End
Item	Cracking			37.200912 °	37.200916 °
				-120.700797 °	-120.700536 °
DWR ID	DWR_NA0010_12_f_2017_10				
Comment Code					
CR1 : Monitor and have inspected by geotechnical engineer.					
Inspector Comment					
Cracking on crown near shoulder approximately 75 feet long should be monitored.

Looking west at the waterside shoulder.

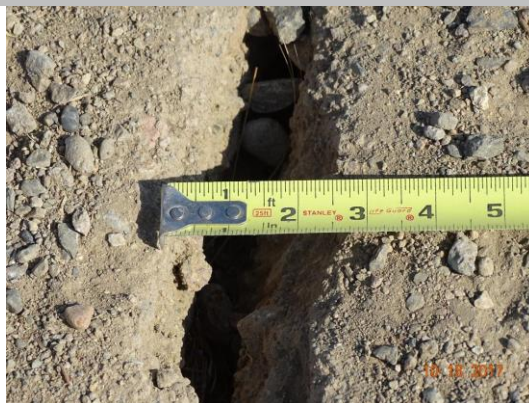
Photo 2 of 3 : SP\_2018\_NA0010\_130\_10\_20180307\_00002.jpg

LM Start	3.00	Rating **	M	Issue No.	10 (cont)	
LM End	3.02	Issue Type +	Ma	Location *	CR	
Category	Earthen Levee			GPS Latitude/Longitude		
				Start		End
Item	Cracking			37.200912 °		37.200916 °
				-120.700797 °		-120.700536 °
DWR ID	DWR_NA0010_12_f_2017_10					
Comment Code						
CR1 : Monitor and have inspected by geotechnical engineer.						
Inspector Comment						
Cracking on crown near shoulder approximately 75 feet long should be monitored.

Typical measurement of the cracking on crown shoulder.

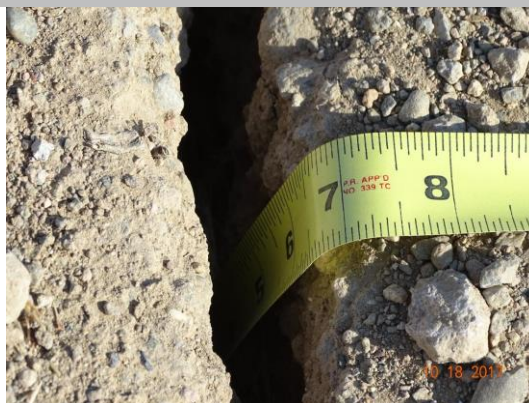
Photo 3 of 3 : SP\_2018\_NA0010\_130\_10\_20180307\_00003.jpg

Typical depth of the cracking on crown shoulder.

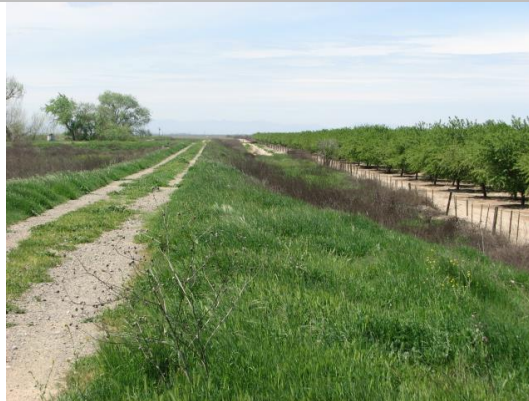
Photo 1 of 1 : SP\_2018\_NA0010\_131\_8\_20180411\_00017.jpg

LM Start	0.00	Rating **	M	Issue No.	8
LM End	1.26	Issue Type +	Ma	Location *	LS
Category	Earthen Levee			GPS Latitude/Longitude	
				Start	End
Item	Vegetation			37.033765 °	37.046311 °
				-120.442120 °	-120.428114 °
DWR ID	DWR_NA0010_13_s_2018_8				
Comment Code					
V1 : Control annual grass and weeds on the levee slopes and easements.					
Inspector Comment

Looking upstream at typical view of landward slope. (Spring 2018)

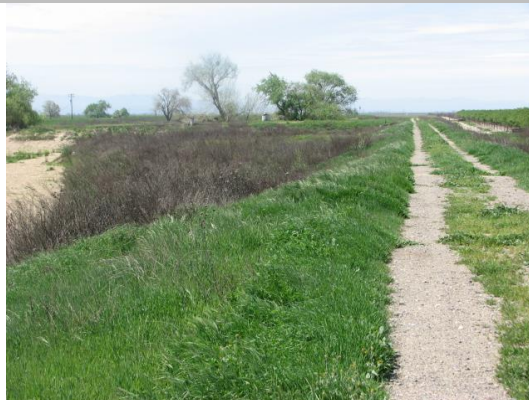
Photo 1 of 1 : SP\_2018\_NA0010\_131\_9\_20180411\_00018.jpg

LM Start	0.00	Rating **	M	Issue No.	9
LM End	1.26	Issue Type +	Ma	Location *	WS
Category	Earthen Levee			GPS Latitude/Longitude	
				Start	End
Item	Vegetation			37.033767 °	37.046311 °
				-120.442121 °	-120.428114 °
DWR ID	DWR_NA0010_13_s_2018_9				
Comment Code					
V1 : Control annual grass and weeds on the levee slopes and easements.					
Inspector Comment

Looking upstream at typical view of waterward slope. (Spring 2018)

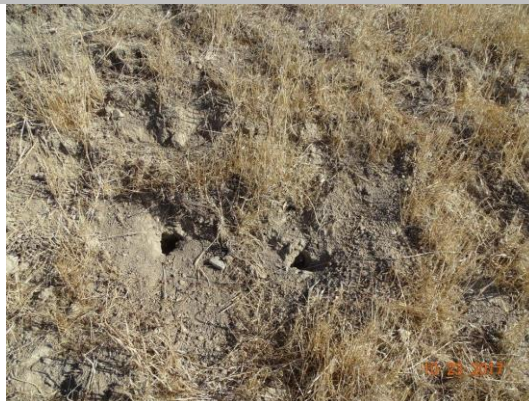
Photo 1 of 1 : SP\_2018\_NA0010\_131\_3\_20180307\_00001.jpg

LM Start	0.15	Rating **	M	Issue No.	3
LM End	0.15	Issue Type +	Ma	Location *	LS
Category	Earthen Levee			GPS Latitude/Longitude	
				Start	End
Item	Animal Control			37.035760 °	37.035760 °
				-120.441282 °	-120.441282 °
DWR ID	DWR_NA0010_13_s_2012_3				
Comment Code					
A3 : No rodents visible, but rodent burrows visible; need to backfill and compact or grout burrows.					
Inspector Comment

Looking at the landside slope.

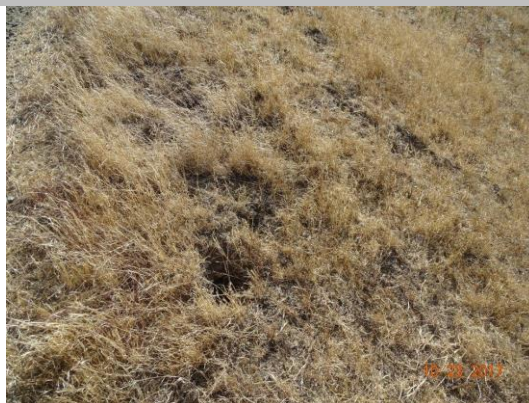
Photo 1 of 1 : SP\_2018\_NA0010\_132\_5\_20180307\_00002.jpg

LM Start	0.25	Rating **	M	Issue No.	5
LM End	0.25	Issue Type +	Ma	Location *	LS
Category	Earthen Levee			GPS Latitude/Longitude	
				Start	End
Item	Animal Control			37.035841 °	37.035841 °
				-120.439795 °	-120.439795 °
DWR ID	DWR_NA0010_14_f_2017_5				
Comment Code					
A3 : No rodents visible, but rodent burrows visible; need to backfill and compact or grout burrows.					
Inspector Comment

Looking at the landside slope.

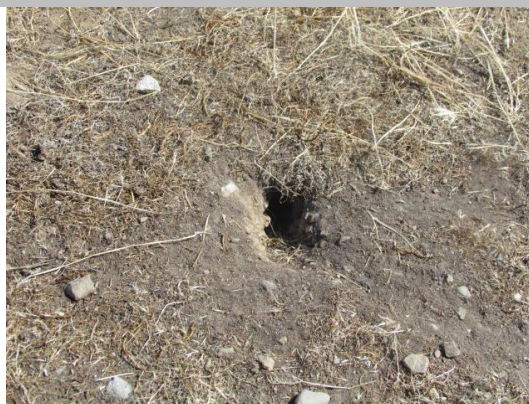
Photo 1 of 1 : SP\_2018\_NA0010\_132\_79\_20180307\_00003.jpg

LM Start	1.24	Rating **	M	Issue No.	79
LM End	1.24	Issue Type +	Ma	Location *	LS
Category	Earthen Levee			GPS Latitude/Longitude	
				Start	End
Item	Animal Control			37.045343 °	37.045343 °
				-120.428007 °	-120.428007 °
DWR ID	DWR_NA0010_14_s_2015_79				
Comment Code					
A3 : No rodents visible, but rodent burrows visible; need to backfill and compact or grout burrows.					
Inspector Comment					
Noted several rodent holes on landside at this location.

Looking at typical view of rodent holes on landward slope.

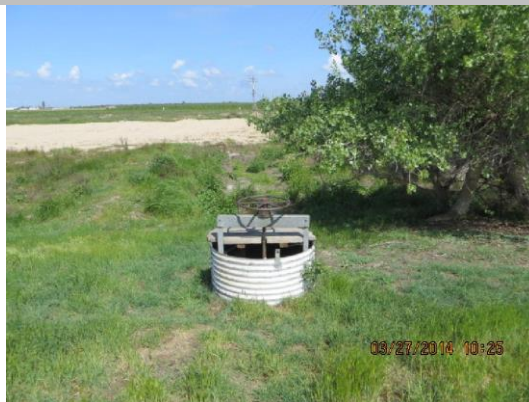
Photo 2 of 3 : UCIP\_SP\_2018\_32828\_59401.jpg

slidegate in CMP riser on WS slope.

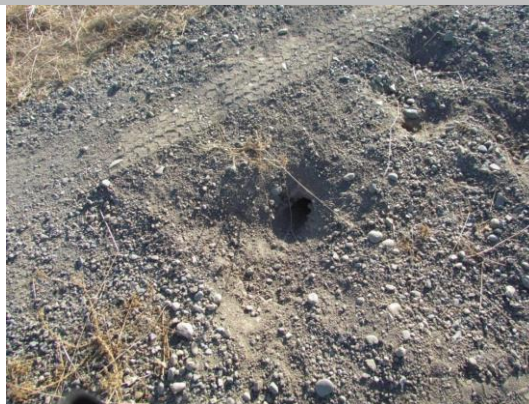
Photo 1 of 1 : SP\_2018\_NA0010\_133\_3\_20180307\_00001.jpg

LM Start	0.37	Rating **	M	Issue No.	3
LM End	0.37	Issue Type +	Ma	Location *	CR
Category	Earthen Levee			GPS Latitude/Longitude	
				Start	End
Item	Animal Control			36.996550 °	36.996550 °
				-120.403647 °	-120.403647 °
DWR ID	DWR_NA0010_15_f_2016_3				
Comment Code					
A3 : No rodents visible, but rodent burrows visible; need to backfill and compact or grout burrows.					
Inspector Comment					
Several rodent holes identified on the levee crown.

Looking at typical rodent holes on levee crown.

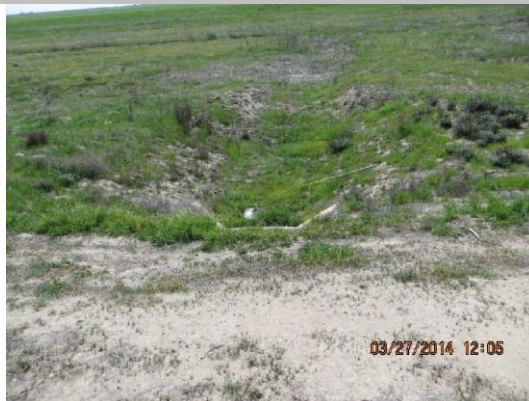
Photo 1 of 3 : UCIP\_SP\_2018\_32838\_59448.jpg

Concrete headwall on WS toe.

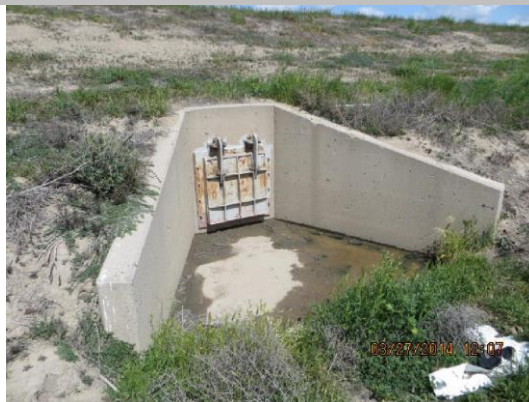
Photo 2 of 3 : UCIP\_SP\_2018\_32838\_59449.jpg

Flapgate on Concrete headwall at WS toe.

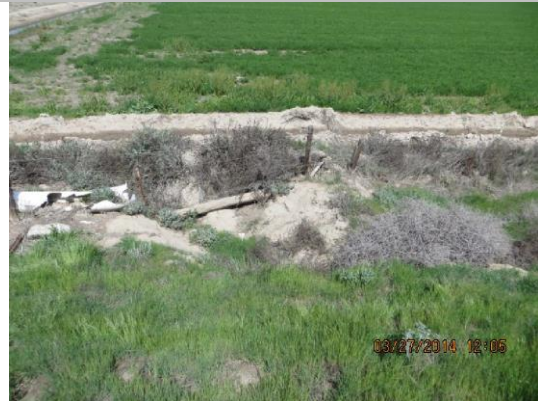
Photo 3 of 3 : UCIP\_SP\_2018\_32838\_59447.jpg

Concrete headwall on LS toe.

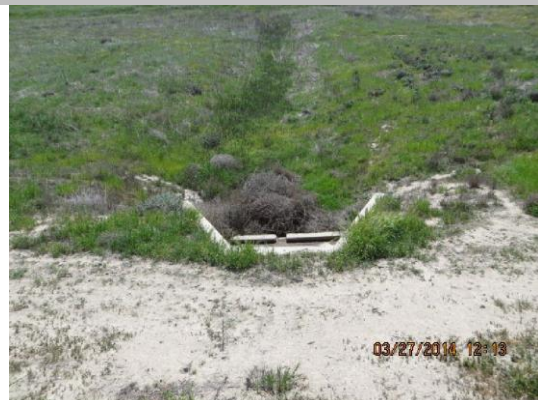
Photo 1 of 3 : UCIP\_SP\_2018\_39527\_59452.jpg

Comment Code					
Inspector Comment					
FS_ID:39527					
DS_ID:19912					
EP_NO: N/A					
Repair Type: Non-Urgent					
Crossing Status: Found					
UCIP Comments: Dense vegetation limits the inspector's visibility to identify signs of pipe failure (leaks) along the landward slope.					
Recommend removing vegetation along pipe alignment to conduct proper inspection of structure.					
FIELD_STRUCT_DESC: 30-inch by 30-inch square reinforced concrete box gravity drainage culvert through the levee, 8.5 feet below the crown. Flap gate on the waterside (WS) end. Concrete headwall on the landside (LS) end. Concrete U-shaped headwall on the WS end.					
[Additional Reference(s): DWR Levee Log, 2002. USACE San Joaquin O&M Manual 601.1, 1967, (HLM 1.01)].					
FS Date: 3/27/2014

Concrete headwall on WS toe.

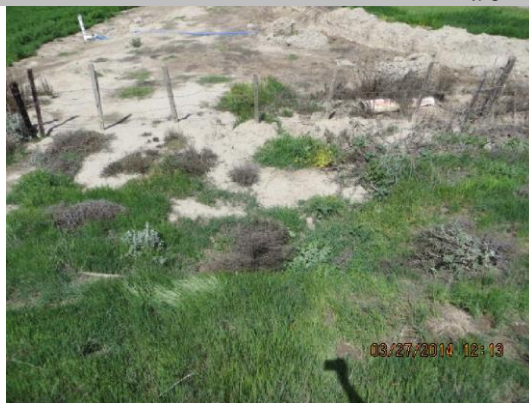
Photo 3 of 3 : UCIP\_SP\_2018\_39527\_59451.jpg

FS\_ID:39527  
DS\_ID:19912  
EP\_NO: N/A  
Repair Type: Non-Urgent  
Crossing Status: Found  
UCIP Comments: Dense vegetation limits the inspector's visibility to identify signs of pipe failure (leaks) along the landward slope. Recommend removing vegetation along pipe alignment to conduct proper inspection of structure.  
FIELD\_STRUCT\_DESC: 30-inch by 30-inch square reinforced concrete box gravity drainage culvert through the levee, 8.5 feet below the crown. Flap gate on the waterside (WS) end. Concrete headwall on the landside (LS) end. Concrete U-shaped headwall on the WS end.  
[Additional Reference(s): DWR Levee Log, 2002. USACE San Joaquin O&M Manual 601.1, 1967, (HLM 1.01)].  
FS Date: 3/27/2014

Concrete headwall on LS toe.

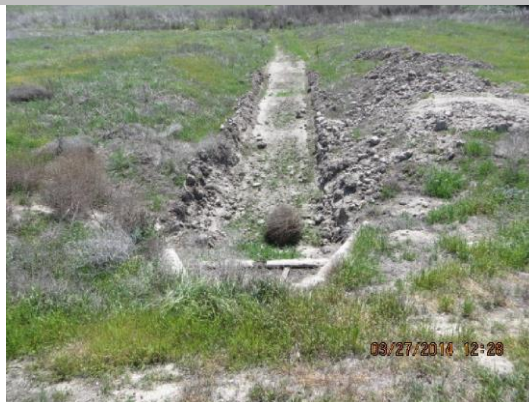
Photo 1 of 3 : UCIP\_SP\_2018\_32840\_59456.jpg

Concrete headwall on WS toe.

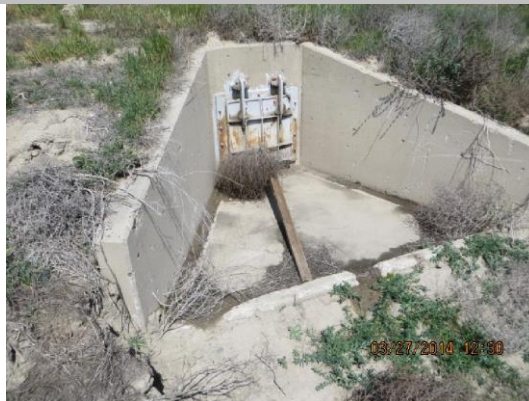
Photo 2 of 3 : UCIP\_SP\_2018\_32840\_59457.jpg

Flapgate on concrete headwall at WS toe.

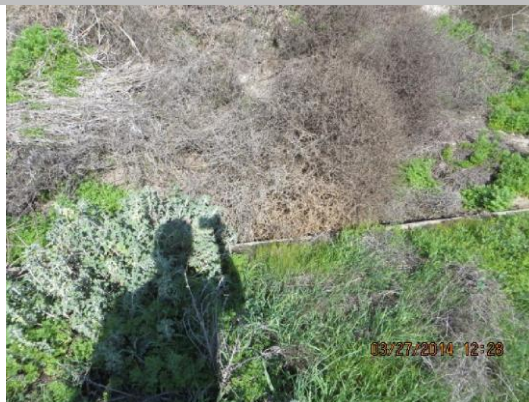
Photo 3 of 3 : UCIP\_SP\_2018\_32840\_59455.jpg

Concrete headwall on LS toe. Note excessive vegetation buildup.

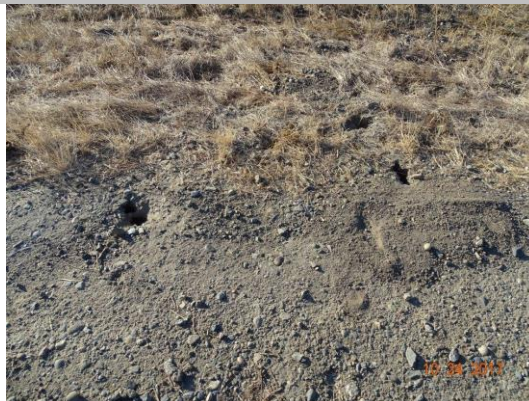
Photo 1 of 1 : SP\_2018\_NA0010\_133\_6\_20180307\_00003.jpg

LM Start	1.58	Rating **	M	Issue No.	6
LM End	2.01	Issue Type +	Ma	Location *	CR
Category	Earthen Levee			GPS Latitude/Longitude	
				Start	End
Item	Animal Control			36.996563 °	36.996578 °
				-120.381895 °	-120.374111 °
DWR ID	DWR_NA0010_15_f_2017_6				
Comment Code					
A3 : No rodents visible, but rodent burrows visible; need to backfill and compact or grout burrows.					
Inspector Comment

Representative picture on the crown.

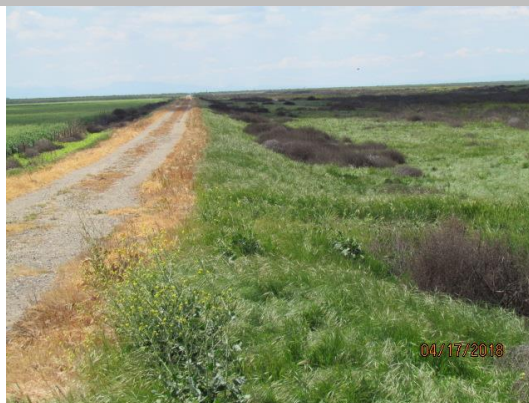
Photo 1 of 1 : SP\_2018\_NA0010\_134\_8\_20180420\_00012.jpg

LM Start	0.00	Rating **	M	Issue No.	8
LM End	1.96	Issue Type +	Ma	Location *	LS
Category	Earthen Levee			GPS Latitude/Longitude	
				Start	End
Item	Vegetation			36.995357 °	36.995497 °
				-120.408923 °	-120.373623 °
DWR ID	DWR_NA0010_16_s_2018_8				
Comment Code					
V1 : Control annual grass and weeds on the levee slopes and easements.					
Inspector Comment

Looking west at typical view of landward slope. (Spring 2018)

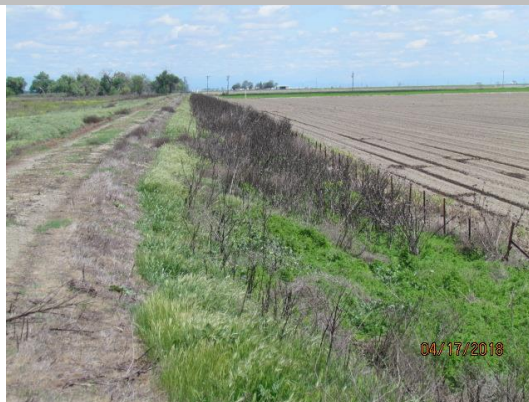
Photo 1 of 1 : SP\_2018\_NA0010\_134\_9\_20180420\_00011.jpg

LM Start	0.00	Rating **	M	Issue No.	9
LM End	1.96	Issue Type +	Ma	Location *	WS
Category	Earthen Levee			GPS Latitude/Longitude	
				Start	End
Item	Vegetation			36.995357 °	36.995497 °
				-120.408923 °	-120.373623 °
DWR ID	DWR_NA0010_16_s_2018_9				
Comment Code					
V1 : Control annual grass and weeds on the levee slopes and easements.					
Inspector Comment

Looking east at typical view of waterward slope. (Spring 2018)

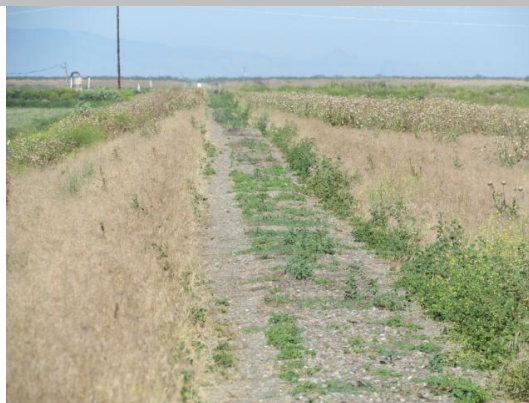
Photo 1 of 1 : SP\_2018\_NA0010\_134\_14\_20180307\_00005.jpg

LM Start	0.01	Rating **	A/W	Issue No.	14
LM End	1.96	Issue Type +	Ma	Location *	CR
Category	Earthen Levee			GPS Latitude/Longitude	
				Start	End
Item	Vegetation			36.995388 °	36.995507 °
				-120.408738 °	-120.373592 °
DWR ID	DWR_NA0010_16_s_2012_14				
Comment Code					
V1 : Control annual grass and weeds on the levee slopes and easements.					
Inspector Comment					
Control vegetation and regrade levee crown.

Looking at typical view of levee crown.

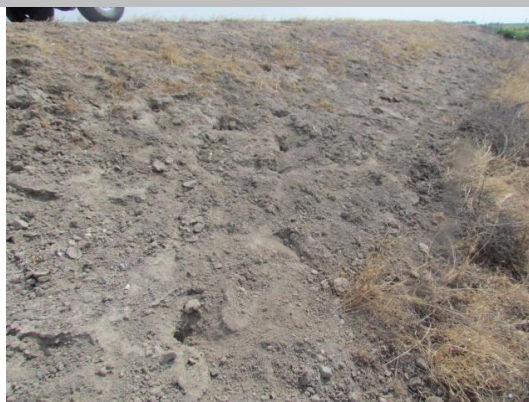
Photo 1 of 1 : SP\_2018\_NA0010\_134\_92\_20180307\_00006.jpg

LM Start	0.93	Rating **	M	Issue No.	92
LM End	0.93	Issue Type +	Ma	Location *	LS
Category	Earthen Levee			GPS Latitude/Longitude	
				Start	End
Item	Animal Control			36.995439 °	36.995439 °
				-120.392146 °	-120.392146 °
DWR ID	DWR_NA0010_16_s_2015_92				
Comment Code					
A3 : No rodents visible, but rodent burrows visible; need to backfill and compact or grout burrows.					
Inspector Comment					
Several rodent holes identified within this section.

Looking at several rodent holes on landward slope.

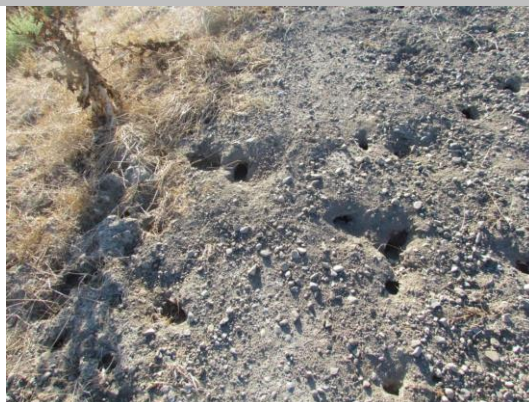
Photo 1 of 1 : SP\_2018\_NA0010\_134\_3\_20180307\_00003.jpg

LM Start	1.09	Rating **	M	Issue No.	3
LM End	1.09	Issue Type +	Ma	Location *	CR
Category	Earthen Levee			GPS Latitude/Longitude	
				Start	End
Item	Animal Control			36.995433 °	36.995433 °
				-120.389190 °	-120.389190 °
DWR ID	DWR_NA0010_16_f_2016_3				
Comment Code					
A3 : No rodents visible, but rodent burrows visible; need to backfill and compact or grout burrows.					
Inspector Comment					
Several rodent holes identified on the levee crown.

Looking at several rodent holes and moles holes on levee crown.

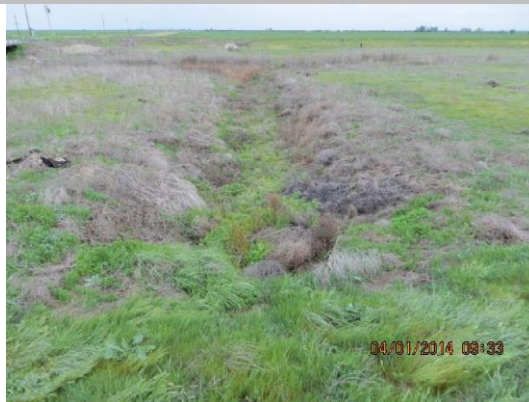
Photo 1 of 3 : UCIP\_SP\_2018\_39529\_59681.jpg

Comment Code					
Inspector Comment					
FS_ID:39529					
DS_ID:19915					
EP_NO: N/A					
Repair Type: Non-Urgent					
Crossing Status: Found					
UCIP Comments: Dense vegetation buildup at landside toe--recommend clearing.					
FIELD_STRUCT_DESC: 30-inch by 30-inch square reinforced concrete box gravity drainage culvert through the levee, 8.5 feet below the crown. Two concrete cutoff walls. Flap gate on the waterside (WS) end. Concrete headwall on the landside (LS) end. Concrete U-shaped headwall on the WS end. [Additional Reference(s): DWR Levee Log, 2002. USACE San Joaquin O&M Manual 601.1, 1967, (HLM 1.46)].					
FS Date: 4/1/2014 8:12:00 AM

Concrete headwall on WS toe with channel.

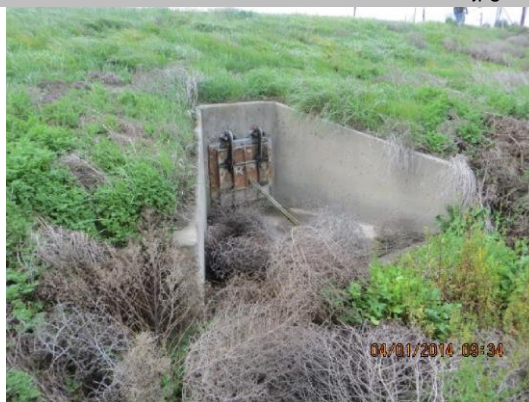
Photo 2 of 3 : UCIP\_SP\_2018\_39529\_59680.jpg

Flapgate on headwall at WS toe.

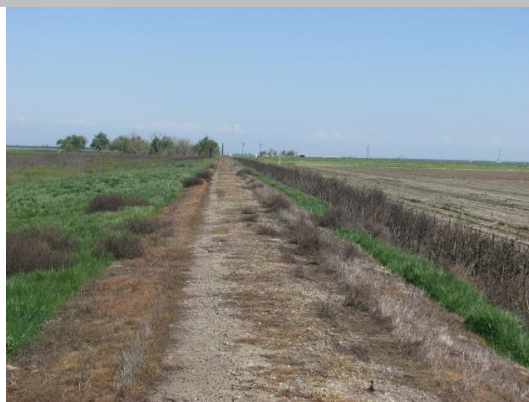
Photo 1 of 1 : SP\_2018\_NA0010\_134\_7\_20180411\_00010.jpg

LM Start	1.46	Rating **	A/W	Issue No.	7
LM End	1.60	Issue Type +	Ma	Location *	CR
Category	Earthen Levee			GPS Latitude/Longitude	
				Start	End
Item	Vegetation			36.995466 °	36.995471 °
				-120.382574 °	-120.380111 °
DWR ID	DWR_NA0010_16_f_2017_7				
Comment Code					
V2 : Remove the wild growth other than native grasses from the levee slopes.					
Inspector Comment

Looking east at typical view of levee crown. (Spring 2018)

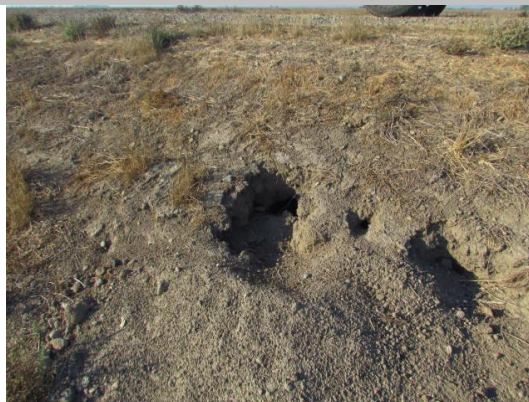
Photo 1 of 2 : SP\_2018\_NA0010\_134\_2\_20180307\_00001.jpg

LM Start	1.77	Rating **	U	Issue No.	2
LM End	1.77	Issue Type +	Ma	Location *	LS
Category	Earthen Levee			GPS Latitude/Longitude	
				Start	End
Item	Animal Control			36.995487 °	36.995487 °
				-120.377054 °	-120.377054 °
DWR ID	DWR_NA0010_16_f_2014_2				
Comment Code					
A3 : No rodents visible, but rodent burrows visible; need to backfill and compact or grout burrows.					
Inspector Comment					
Large rodent holes on landside slope.

Looking at large rodent holes on landward slope.

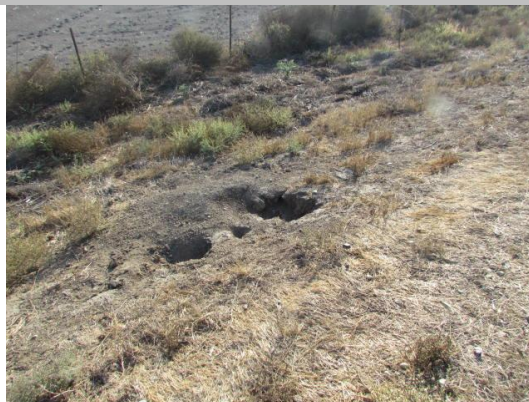
Photo 2 of 2 : SP\_2018\_NA0010\_134\_2\_20180307\_00002.jpg

Looking southwest at several rodent holes on landward slope.

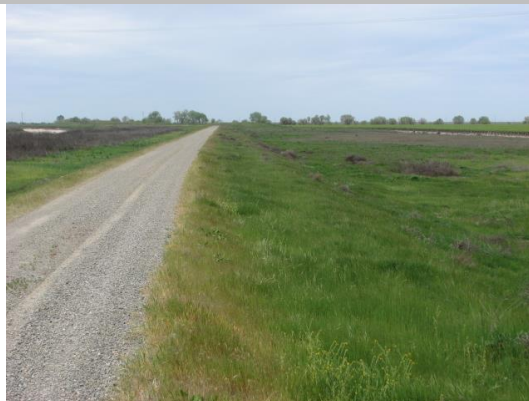
Photo 1 of 1 : SP\_2018\_NA0010\_135\_13\_20180411\_00037.jpg

LM Start	0.00	Rating **	M	Issue No.	13
LM End	16.09	Issue Type +	Ma	Location *	LS
Category	Earthen Levee			GPS Latitude/Longitude	
				Start	End
Item	Vegetation			36.976461 °	36.774440 °
				-120.374672 °	-120.283749 °
DWR ID	DWR_NA0010_17_s _ 2018_13				
Comment Code					
V1 : Control annual grass and weeds on the levee slopes and easements.					
Inspector Comment

Looking upstream (south) at typical view of landward slope. (Spring 2018)

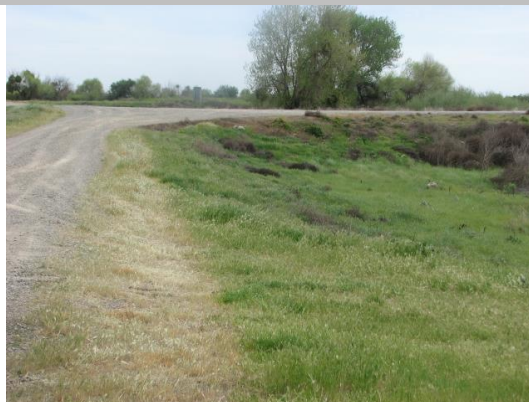
Photo 1 of 1 : SP\_2018\_NA0010\_135\_14\_20180411\_00038.jpg

LM Start	0.00	Rating **	M	Issue No.	14
LM End	16.09	Issue Type +	Ma	Location *	WS
Category	Earthen Levee			GPS Latitude/Longitude	
				Start	End
Item	Vegetation			36.976462 °	36.774440 °
				-120.374672 °	-120.283749 °
DWR ID	DWR_NA0010_17_s _ 2018_14				
Comment Code					
V1 : Control annual grass and weeds on the levee slopes and easements.					
Inspector Comment

Looking upstream (south) at typical view of waterward slope. (Spring 2018)

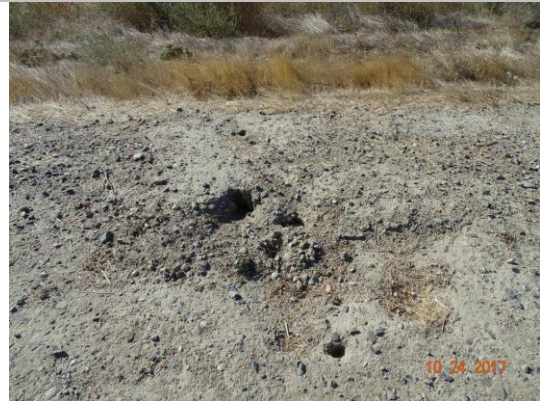
Photo 1 of 1 : SP\_2018\_NA0010\_135\_18\_20180307\_00007.jpg

LM Start	0.64	Rating **	M	Issue No.	18
LM End	0.64	Issue Type +	Ma	Location *	CR
Category	Earthen Levee			GPS Latitude/Longitude	
				Start	End
Item	Animal Control			36.976181 °	36.976181 °
				-120.363241 °	-120.363241 °
DWR ID	DWR_NA0010_17_f_2017_18				
Comment Code					
A3 : No rodents visible, but rodent burrows visible; need to backfill and compact or grout burrows.					
Inspector Comment					
Multiple rodent holes in this area.

Looking at the crown.

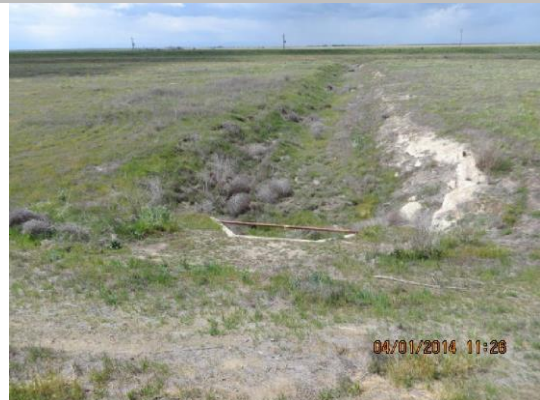
Photo 1 of 3 : UCIP\_SP\_2018\_39531\_59710.jpg

Comment Code						
Inspector Comment						
FS_ID:39531 DS_ID:19916 EP_NO: N/A Repair Type: Non-Urgent Crossing Status: Found UCIP Comments: Dense vegetation limits the inspector's visibility to identify signs of pipe failure (leaks) along the landward slope. Recommend removing vegetation along pipe alignment to conduct proper inspection of structure. FIELD_STRUCT_DESC: 48-inch by 60-inch reinforced concrete box gravity drainage culvert through the levee, 14.6 feet below the crown. Flap gate on the waterside (WS) end. Concrete headwall on the landside (LS) end. Concrete U-shaped headwall on the WS end. [Additional Reference(s): DWR Levee Log, 2002. USACE San Joaquin O&M Manual 601.1, 1967, (HLM 2.58)]. FS Date: 4/1/2014

Concrete headwall at channel on WS toe.

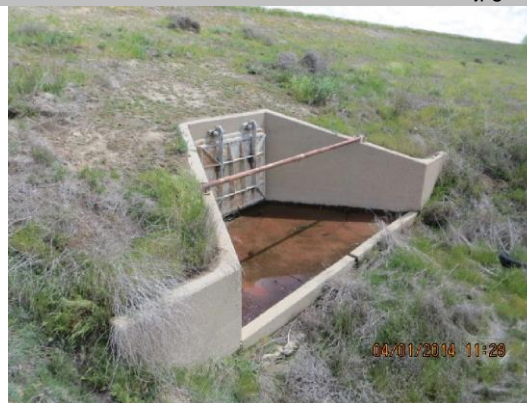
Photo 2 of 3 : UCIP\_SP\_2018\_39531\_59711.jpg

Comment Code						
Inspector Comment						
FS_ID:39531						
DS_ID:19916						
EP_NO: N/A						
Repair Type: Non-Urgent						
Crossing Status: Found						
UCIP Comments: Dense vegetation limits the inspector's visibility to identify signs of pipe failure (leaks) along the landward slope.						
Recommend removing vegetation along pipe alignment to conduct proper inspection of structure.						
FIELD_STRUCT_DESC: 48-inch by 60-inch reinforced concrete box gravity drainage culvert through the levee, 14.6 feet below the crown.						
Flap gate on the waterside (WS) end. Concrete headwall on the landside (LS) end. Concrete U-shaped headwall on the WS end.						
[Additional Reference(s): DWR Levee Log, 2002. USACE San Joaquin O&M Manual 601.1, 1967, (HLM 2.58)].						
FS Date: 4/1/2014

Flapgate on Concrete headwall at WS toe.

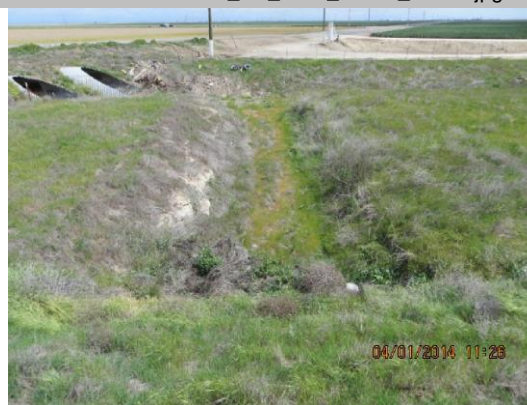
Photo 3 of 3 : UCIP\_SP\_2018\_39531\_59709.jpg

Concrete headwall at LS toe.

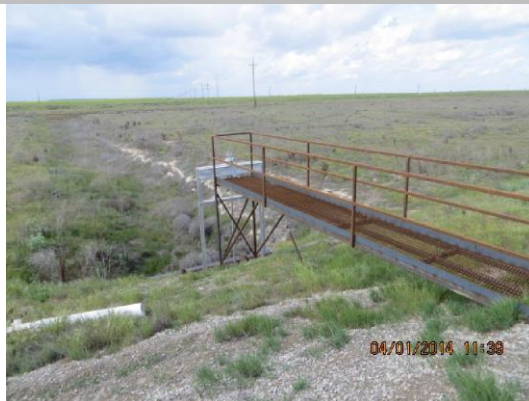
Photo 1 of 3 : UCIP\_SP\_2018\_32998\_59714.jpg

FS\_ID:32998  
DS\_ID:19921  
EP\_NO: N/A  
Repair Type: No Action Needed  
Crossing Status: Found  
UCIP Comments:  
FIELD\_STRUCT\_DESC: 48-inch by 60-inch reinforced concrete box gravity drainage culvert through the levee, 14.6 feet below the crown. Concrete U-shaped headwall on the waterside (WS) end. 36-inch weir structure on the WS. Combination flap gate and slide gate on the WS toe. Steel walkway to slide gate actuator on the WS shoulder. (Plans to construct a 3.281-foot-high weir and attach a cable operated flap valve to an existing 48-inch by 60-inch culvert authorized under Permit No. 13587, 1983 - Clark Brothers Farming, Arroyo Ranch). [Additional Reference(s): DWR Levee Log, 2002. USACE San Joaquin O&M Manual 601.1, 1967, (HLM 4.69)].  
FS Date: 4/1/2014

Steel walkway to slide gate actuator on WS shoulder.

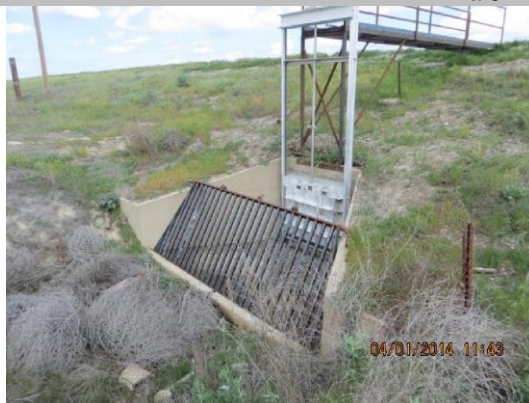
Photo 2 of 3 : UCIP\_SP\_2018\_32998\_59715.jpg

Combination flapgate/slidegate, concrete headwall, and metal screen at WS toe.

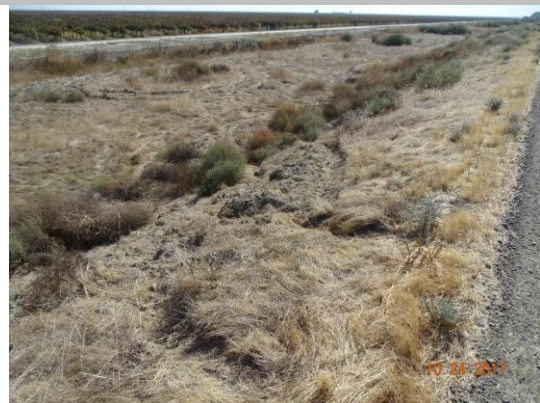
Photo 1 of 1 : SP\_2018\_NA0010\_135\_22\_20180307\_00009.jpg

LM Start	4.74	Rating **	M	Issue No.	22
LM End	4.74	Issue Type +	Ma	Location *	LS
Category	Earthen Levee			GPS Latitude/Longitude	
				Start	End
Item	Slope Stability			36.922526 °	36.922526 °
				-120.336227 °	-120.336227 °
DWR ID	DWR_NA0010_17_f_2017_22				
Comment Code					
S3 : Repair the levee slope damaged by vehicle traffic and prevent access where possible.					
Inspector Comment

Looking southeast at the landside slope.

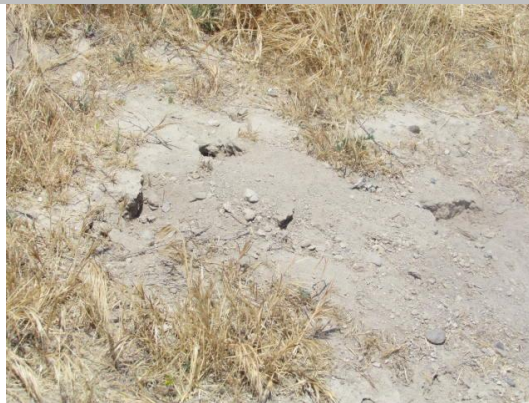
Photo 1 of 2 : SP\_2018\_NA0010\_135\_8\_20180307\_00005.jpg

LM Start	5.75	Rating **	M	Issue No.	8
LM End	5.90	Issue Type +	Ma	Location *	LS
Category	Earthen Levee			GPS Latitude/Longitude	
				Start	End
Item	Animal Control			36.908605 °	36.906507 °
				-120.331112 °	-120.330353 °
DWR ID	DWR_NA0010_17_s_2012_8				
Comment Code					
A1 : Exterminate rodents and backfill and compact or grout burrows.					
Inspector Comment					
Multiple rodent holes noted on landside slope.

Looking at several rodent holes on landward slope. (Spring 2015)

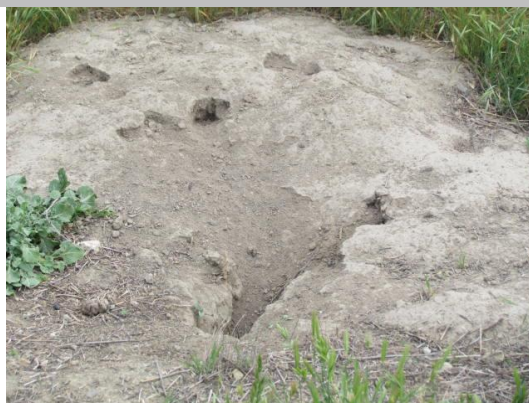
Photo 2 of 2 : SP\_2018\_NA0010\_135\_8\_20180307\_00006.jpg

Looking at several rodent holes on landside slope. (Fall 2014)

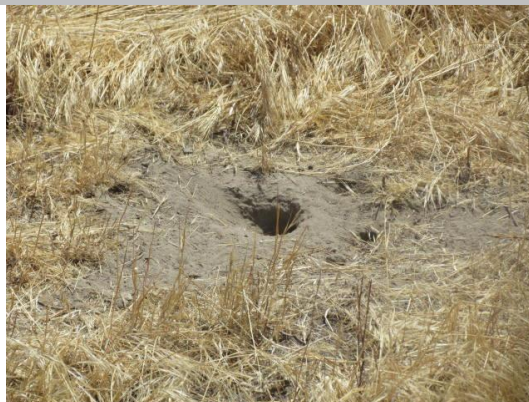
Photo 1 of 1 : SP\_2018\_NA0010\_135\_4\_20180307\_00003.jpg

LM Start	6.51	Rating **	M	Issue No.	4
LM End	6.72	Issue Type +	Ma	Location *	LS
Category	Earthen Levee			GPS Latitude/Longitude	
				Start	End
Item	Animal Control			36.898093 °	36.895300 °
				-120.326689 °	-120.325322 °
DWR ID	DWR_NA0010_17_s_2012_4				
Comment Code					
A1 : Exterminate rodents and backfill and compact or grout burrows.					
Inspector Comment					
Several rodent holes identified within this reach.

Looking at typical view of rodent holes on landward slope.

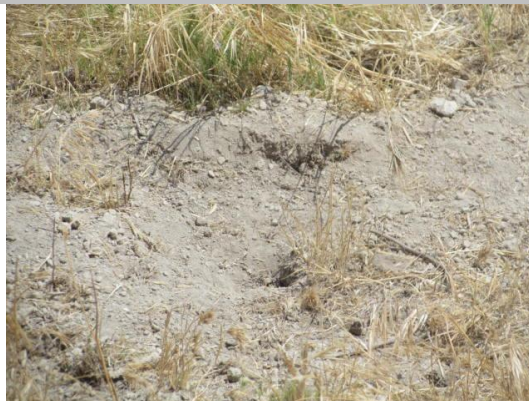
Photo 1 of 1 : SP\_2018\_NA0010\_135\_5\_20180307\_00004.jpg

LM Start	7.27	Rating **	M	Issue No.	5
LM End	7.38	Issue Type +	Ma	Location *	LS
Category	Earthen Levee			GPS Latitude/Longitude	
				Start	End
Item	Animal Control			36.887852 °	36.886388 °
				-120.321668 °	-120.320950 °
DWR ID	DWR_NA0010_17_s_2012_5				
Comment Code					
A3 : No rodents visible, but rodent burrows visible; need to backfill and compact or grout burrows.					
Inspector Comment					
Several rodent holes identified within this reach.

Looking at typical view of rodent holes on landward slope.

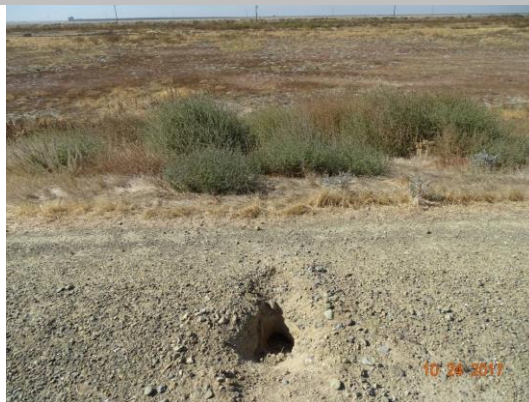
Photo 1 of 1 : SP\_2018\_NA0010\_135\_23\_20180307\_00010.jpg

LM Start	7.41	Rating **	M	Issue No.	23
LM End	7.41	Issue Type +	Ma	Location *	CR
Category	Earthen Levee			GPS Latitude/Longitude	
				Start	End
Item	Animal Control			36.885998 °	36.885998 °
				-120.320759 °	-120.320759 °
DWR ID	DWR_NA0010_17_f_2017_23				
Comment Code					
A3 : No rodents visible, but rodent burrows visible; need to backfill and compact or grout burrows.					
Inspector Comment

Looking southwest at the crown.

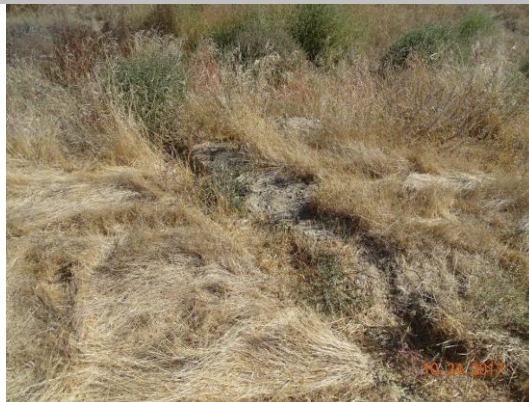
Photo 1 of 1 : SP\_2018\_NA0010\_135\_24\_20180307\_00011.jpg

LM Start	8.15	Rating **	M	Issue No.	24
LM End	8.15	Issue Type +	Ma	Location *	LS
Category	Earthen Levee			GPS Latitude/Longitude	
				Start	End
Item	Animal Control			36.875525 °	36.875525 °
				-120.317788 °	-120.317788 °
DWR ID	DWR_NA0010_17_f_2017_24				
Comment Code					
A3 : No rodents visible, but rodent burrows visible; need to backfill and compact or grout burrows.					
Inspector Comment					
Rodent holes on landside and crown of levee. Rodent holes have caused some erosion on the landside slope.

Looking east at the landside slope.

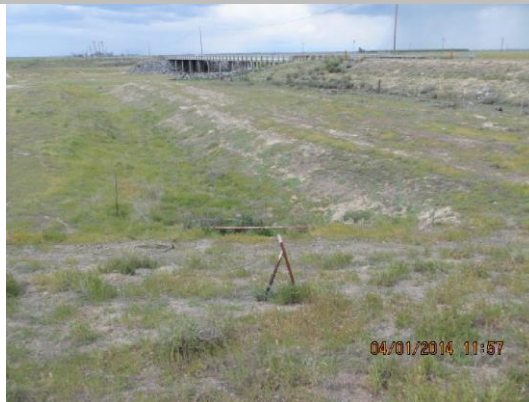
Photo 1 of 3 : UCIP\_SP\_2018\_32999\_59718.jpg

FS\_ID:32999  
DS\_ID:19922  
EP\_NO: N/A  
Repair Type: No Action Needed  
Crossing Status: Found  
UCIP Comments:  
FIELD\_STRUCT\_DESC: 48-inch by 60-inch reinforced concrete box gravity drainage culvert through the levee, 16.5 feet below the crown. Flap gate on the waterside (WS) end. Concrete headwall on the landside (LS) end. Concrete U-shaped headwall on the WS end. [Additional Reference(s): DWR Levee Log, 2002. USACE San Joaquin O&M Manual 601.1, 1967, (HLM 8.38)].  
FS Date: 4/1/2014

Concrete headwall and channel on WS toe.

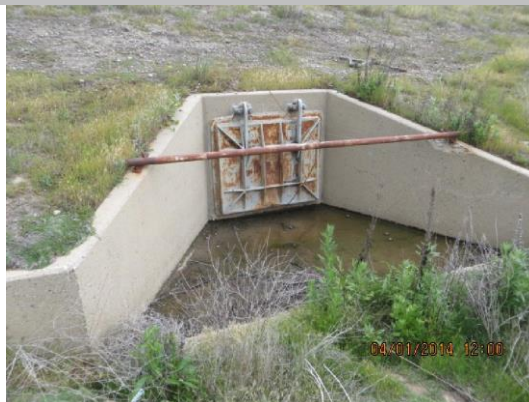
Photo 2 of 3 : UCIP\_SP\_2018\_32999\_59720.jpg

Flapgate on concrete headwall at WS toe.

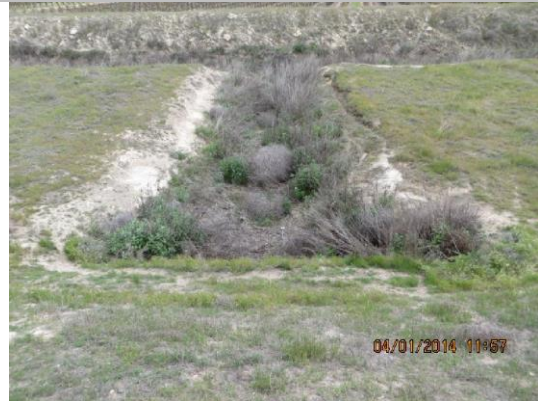
Photo 3 of 3 : UCIP\_SP\_2018\_32999\_59719.jpg

LM Start	8.37	Rating **	A/W	Issue No.	27 (cont)	
LM End	8.37	Issue Type +	Ma	Location *		
Category	Supplemental			GPS Latitude/Longitude		
				Start	End	
Item	DWR UCIP LMA Responsibility			36.872358 °	36.872358 °	
				-120.317170 °	-120.317170 °	
DWR ID						
Comment Code						
Inspector Comment						
FS_ID:32999						
DS_ID:19922						
EP_NO: N/A						
Repair Type: No Action Needed						
Crossing Status: Found						
UCIP Comments:						
FIELD_STRUCT_DESC: 48-inch by 60-inch reinforced concrete box gravity drainage culvert through the levee, 16.5 feet below the crown. Flap gate on the waterside (WS) end. Concrete headwall on the landside (LS) end. Concrete U-shaped headwall on the WS end. [Additional Reference(s): DWR Levee Log, 2002. USACE San Joaquin O&M Manual 601.1, 1967, (HLM 8.38)].						
FS Date: 4/1/2014

Concrete headwall and channel on LS toe.
