**Flood Control Project Maintenance  
Levee Inspections**

## Maintenance Issue Types Only, Levee Inspection Report By Mile - Spring 2018

### Lower San Joaquin Levee District

Waterway	Bank	Unit Miles	Inspection Start/End	Inspector
Unit No. 01 San Joaquin River	Right	22.52	04/04/2018 04/16/2018	Richard Willoughby

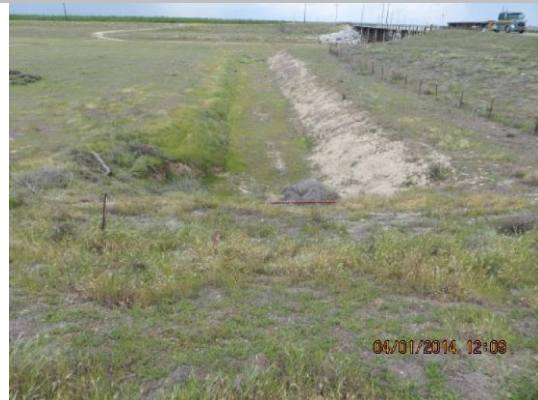
Photo 1 of 3 : UCIP\_SP\_2018\_39532\_59723.jpg

Comment Code					
Inspector Comment					
FS_ID:39532					
DS_ID:19917					
EP_NO: N/A					
Repair Type: Non-Urgent					
Crossing Status: Found					
UCIP Comments: Dense vegetation limits the inspector's visibility to identify signs of pipe failure (leaks) along the landward slope. Recommend removing vegetation along pipe alignment to conduct proper inspection of structure.					
FIELD_STRUCT_DESC: 48-inch by 60-inch reinforced concrete box gravity drainage culvert through the levee, 15 feet below the crown. Concrete headwall on the landside (LS) end. Concrete U-shaped headwall on the waterside (WS) end. [Additional Reference(s): DWR Levee Log, 2002. USACE San Joaquin O&M Manual 601.1, 1967, (HLM 9.89)].					
FS Date: 4/1/2014

Concrete headwall and channel on WS toe.

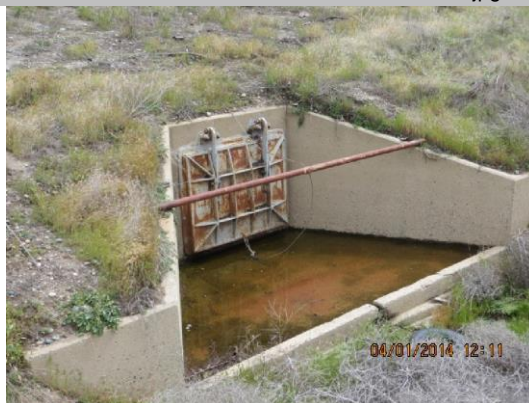
Photo 2 of 3 : UCIP\_SP\_2018\_39532\_59724.jpg

Comment Code						
Inspector Comment						
FS_ID:39532						
DS_ID:19917						
EP_NO: N/A						
Repair Type: Non-Urgent						
Crossing Status: Found						
UCIP Comments: Dense vegetation limits the inspector's visibility to identify signs of pipe failure (leaks) along the landward slope.						
Recommend removing vegetation along pipe alignment to conduct proper inspection of structure.						
FIELD_STRUCT_DESC: 48-inch by 60-inch reinforced concrete box gravity drainage culvert through the levee, 15 feet below the crown.						
Concrete headwall on the landside (LS) end. Concrete U-shaped headwall on the waterside (WS) end. [Additional Reference(s): DWR Levee Log, 2002. USACE San Joaquin O&M Manual 601.1, 1967, (HLM 9.89)].						
FS Date: 4/1/2014

Flapgate on Concrete headwall at WS toe.

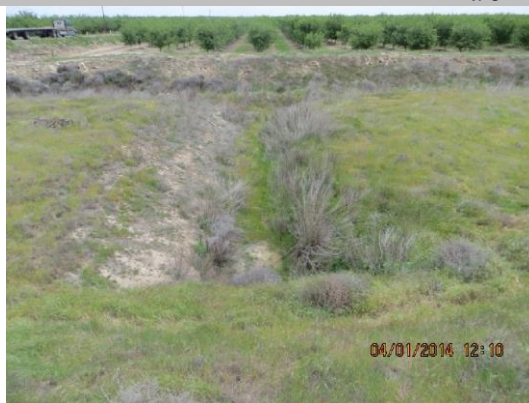
Photo 3 of 3 : UCIP\_SP\_2018\_39532\_59722.jpg

Concrete headwall and channel on LS toe.

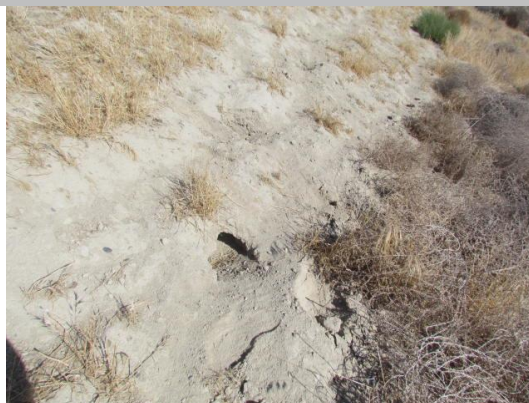
Photo 1 of 2 : SP\_2018\_NA0010\_135\_3\_20180307\_00001.jpg

Looking at typical view of rodent holes on landward slope. Fall 2015

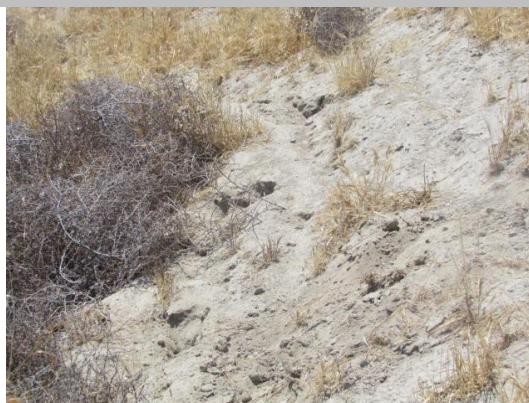
Photo 2 of 2 : SP\_2018\_NA0010\_135\_3\_20180307\_00002.jpg

Looking at several rodent holes on landward slope. Spring 2015

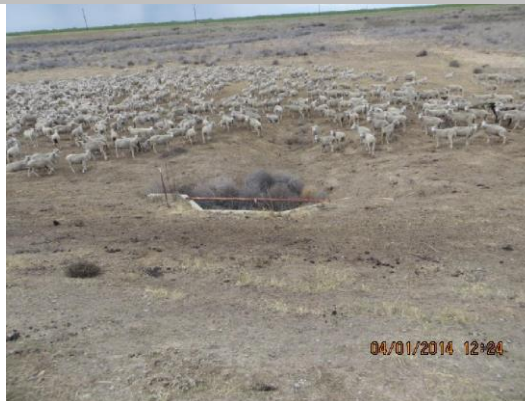
Photo 1 of 3 : UCIP\_SP\_2018\_39533\_59727.jpg

LM Start	13.29	Rating **	M	Issue No.	29
LM End	13.29	Issue Type +	Ma	Location *	
Category	Supplemental			GPS Latitude/Longitude	
				Start	End
Item	DWR UCIP LMA Responsibility			36.807509 °	36.807509 °
				-120.306231 °	-120.306231 °
DWR ID					
Comment Code					
Inspector Comment					
FS_ID:39533 DS_ID:19918 EP_NO: N/A Repair Type: Non-Urgent Crossing Status: Found UCIP Comments: Some vegetation buildup at inlet--recommend clearing. FIELD_STRUCT_DESC: 48-inch by 60-inch reinforced concrete box gravity drainage culvert through the levee, 15.3 feet below the crown. Flap gate on the waterside (WS) end. Concrete headwall on the landside (LS) end. Concrete U-shaped headwall on the WS end. [Additional Reference(s): DWR Levee Log, 2002. USACE San Joaquin O&M Manual 601.1, 1967, (HLM 13.30)]. FS Date: 4/1/2014

Concrete headwall on WS toe.

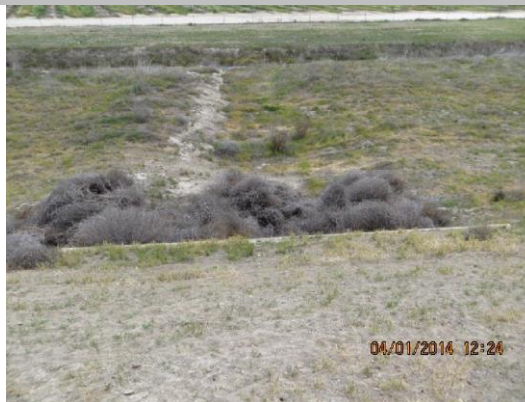
Photo 2 of 3 : UCIP\_SP\_2018\_39533\_59726.jpg

Concrete headwall on LS toe.

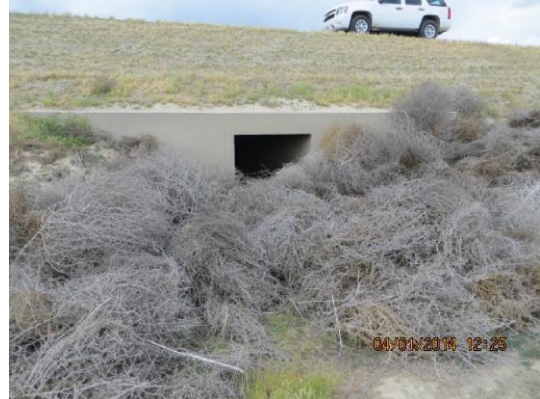
Photo 3 of 3 : UCIP\_SP\_2018\_39533\_59725.jpg

LM Start	13.29	Rating **	M	Issue No.	29 (cont)
LM End	13.29	Issue Type +	Ma	Location *	
Category	Supplemental			GPS Latitude/Longitude	
				Start	End
Item	DWR UCIP LMA Responsibility			36.807509 °	36.807509 °
				-120.306231 °	-120.306231 °
DWR ID					
Comment Code					
Inspector Comment					
FS_ID:39533 DS_ID:19918 EP_NO: N/A Repair Type: Non-Urgent Crossing Status: Found UCIP Comments: Some vegetation buildup at inlet--recommend clearing. FIELD_STRUCT_DESC: 48-inch by 60-inch reinforced concrete box gravity drainage culvert through the levee, 15.3 feet below the crown. Flap gate on the waterside (WS) end. Concrete headwall on the landside (LS) end. Concrete U-shaped headwall on the WS end. [Additional Reference(s): DWR Levee Log, 2002. USACE San Joaquin O&M Manual 601.1, 1967, (HLM 13.30)]. FS Date: 4/1/2014

Concrete headwall on LS toe. Some vegetation buildup.

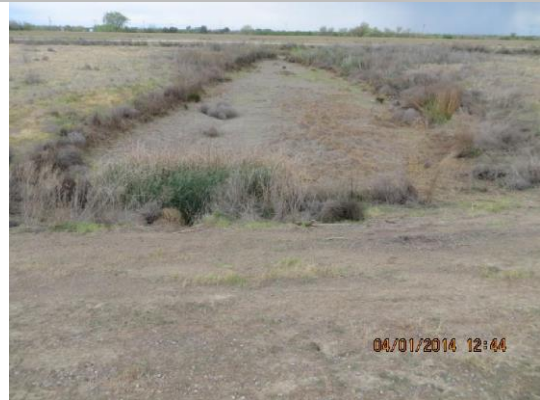
Photo 1 of 3 : UCIP\_SP\_2018\_39535\_59745.jpg

LM Start	14.69	Rating **	M	Issue No.	32
LM End	14.69	Issue Type +	Ma	Location *	
Category	Supplemental			GPS Latitude/Longitude	
				Start	End
Item	DWR UCIP LMA Responsibility			36.789066 °	36.789066 °
				-120.300644 °	-120.300644 °
DWR ID					
Comment Code					
Inspector Comment					
FS_ID:39535					
DS_ID:19920					
EP_NO: N/A					
Repair Type: Non-Urgent					
Crossing Status: Found					
UCIP Comments: Heavy vegetation buildup at LS toe--recommend clearing.					
FIELD_STRUCT_DESC: 30-inch by 30-inch square reinforced concrete box gravity drainage culvert through the levee, 14 feet below the crown. Flap gate on the waterside (WS) end. Concrete headwall on the landside (LS) end. Concrete U-shaped headwall on the WS end.					
[Additional Reference(s): DWR Levee Log, 2002. USACE San Joaquin O&M Manual 601.1, 1967, (HLM 14.69)].					
FS Date: 4/1/2014

Concrete headwall at WS toe.

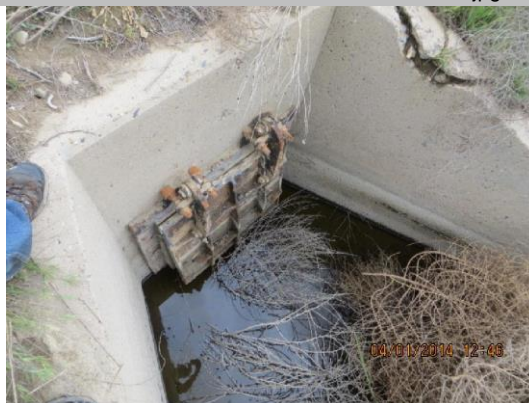
Photo 2 of 3 : UCIP\_SP\_2018\_39535\_59747.jpg

Flapgate on Concrete headwall at WS toe.

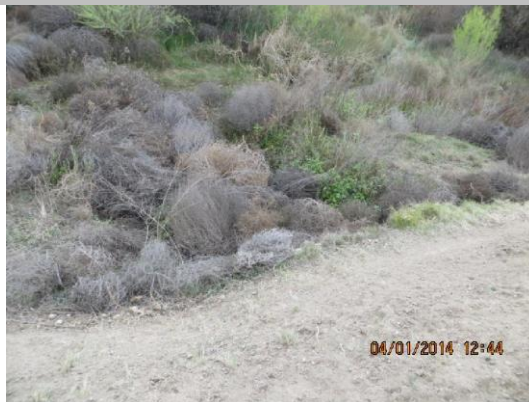
Photo 3 of 3 : UCIP\_SP\_2018\_39535\_59746.jpg

Concrete headwall at channel on LS toe. Heavy vegetation buildup.

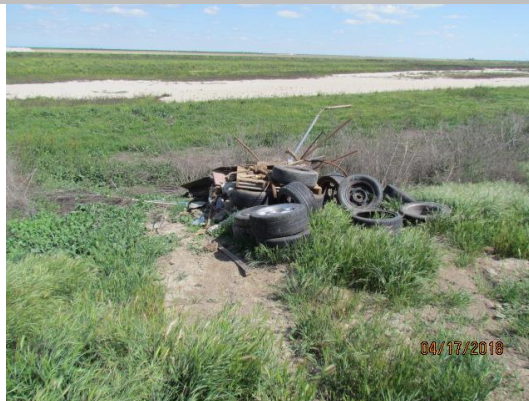
Photo 1 of 1 : SP\_2018\_NA0010\_137\_20\_20180420\_00022.jpg

LM Start	0.58	Rating **	U	Issue No.	20
LM End	0.58	Issue Type +	Ma	Location *	WS
Category	Earthen Levee			GPS Latitude/Longitude	
				Start	End
Item	Encroachments			36.967678 °	36.967678 °
				-120.357660 °	-120.357660 °
DWR ID	DWR_NA0010_18_s_2018_20				
Comment Code					
GA : Garbage					
Inspector Comment					
Garbage (rubber tires) stockpile on waterward slope.

Looking east at garbage (rubber tires) on waterward slope. (Spring 2018)

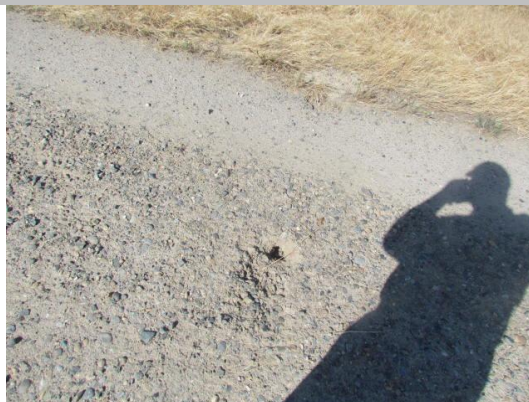
Photo 1 of 1 : SP\_2018\_NA0010\_137\_7\_20180307\_00003.jpg

LM Start	1.44	Rating **	M	Issue No.	7
LM End	1.44	Issue Type +	Ma	Location *	LS
Category	Earthen Levee			GPS Latitude/Longitude	
				Start	End
Item	Animal Control			36.956163 °	36.956163 °
				-120.353672 °	-120.353672 °
DWR ID	DWR_NA0010_18_s_2014_7				
Comment Code					
A3 : No rodents visible, but rodent burrows visible; need to backfill and compact or grout burrows.					
Inspector Comment					
Several holes identified on landside slope and on the levee crown.

Looking at typical view of rodent holes within this section on landward slope.

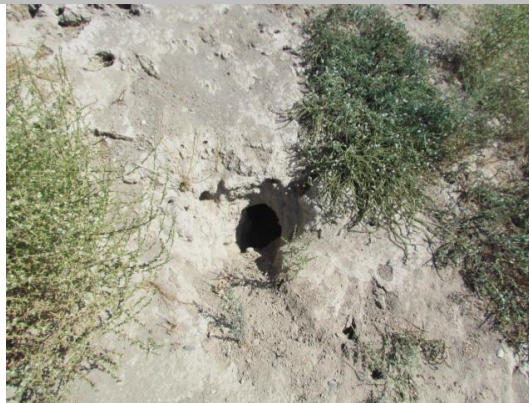
Photo 1 of 2 : SP\_2018\_NA0010\_137\_8\_20180307\_00004.jpg

LM Start	2.25	Rating **	U	Issue No.	8
LM End	2.25	Issue Type +	Ma	Location *	LS
Category	Earthen Levee			GPS Latitude/Longitude	
				Start	End
Item	Animal Control			36.945563 °	36.945563 °
				-120.347121 °	-120.347121 °
DWR ID	DWR_NA0010_18_f_2015_8				
Comment Code					
A3 : No rodents visible, but rodent burrows visible; need to backfill and compact or grout burrows.					
Inspector Comment					
One large rodent hole and other rodent holes within this area.

Looking at large rodent hole on landward slope.

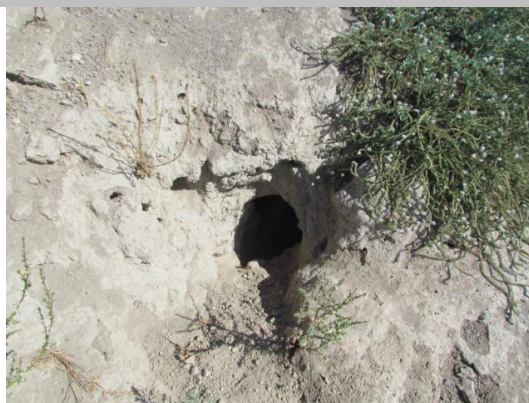
Photo 2 of 2 : SP\_2018\_NA0010\_137\_8\_20180307\_00005.jpg

Looking at close-up view of large rodent hole on landward slope.

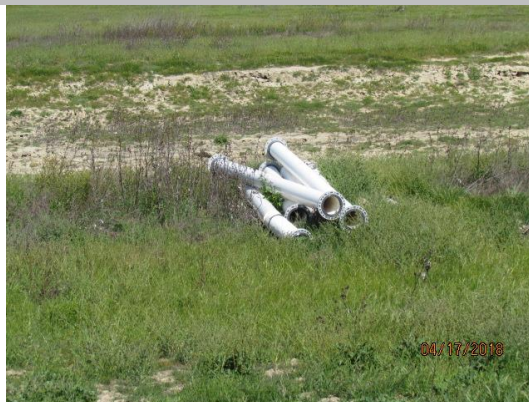
Photo 1 of 1 : SP\_2018\_NA0010\_137\_17\_20180420\_00023.jpg

LM Start	3.68	Rating **	M	Issue No.	17
LM End	3.68	Issue Type +	Ma	Location *	WS
Category	Earthen Levee			GPS Latitude/Longitude	
				Start	End
Item	Encroachments			36.925683 °	36.925683 °
				-120.339692 °	-120.339692 °
DWR ID	DWR_NA0010_18_s_2018_17				
Comment Code					
PI : Pipe					
Inspector Comment					
Remove Irrigation pipes stored in channel.

Looking east at irrigation pipe stored in channel. (Spring 2018)

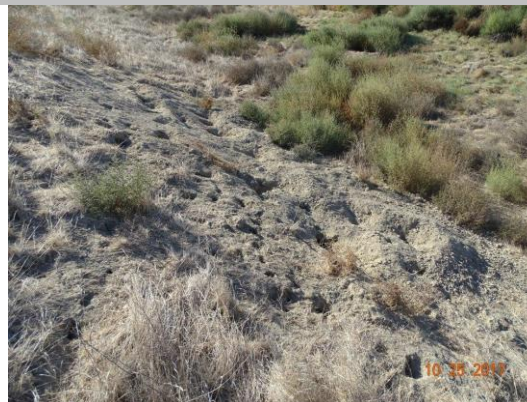
Photo 1 of 1 : SP\_2018\_NA0010\_137\_1\_20180307\_00001.jpg

LM Start	5.89	Rating **	U	Issue No.	1
LM End	5.89	Issue Type +	Ma	Location *	LS
Category	Earthen Levee			GPS Latitude/Longitude	
				Start	End
Item	Animal Control			36.895175 °	36.895175 °
				-120.327632 °	-120.327632 °
DWR ID	DWR_NA0010_18_s_2015_1				
Comment Code					
A3 : No rodents visible, but rodent burrows visible; need to backfill and compact or grout burrows.					
Inspector Comment					
Several large rodent holes noted on landside slope and berm within this section.

Looking at the landside slope.

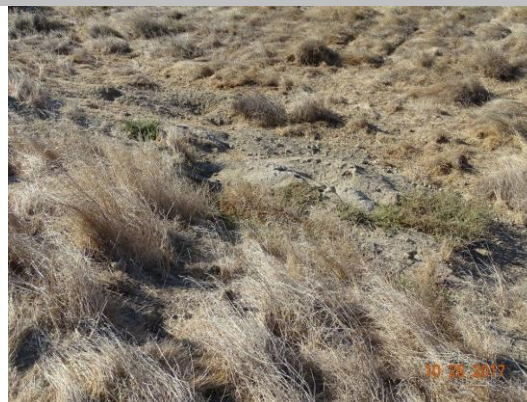
Photo 1 of 1 : SP\_2018\_NA0010\_137\_15\_20180307\_00008.jpg

LM Start	5.99	Rating **	U	Issue No.	15
LM End	5.99	Issue Type +	Ma	Location *	LS
Category	Earthen Levee			GPS Latitude/Longitude	
				Start	End
Item	Animal Control			36.893924 °	36.893924 °
				-120.327020 °	-120.327020 °
DWR ID	DWR_NA0010_18_f_2017_15				
Comment Code					
A3 : No rodents visible, but rodent burrows visible; need to backfill and compact or grout burrows.					
Inspector Comment					
Multiple large rodent holes at the landside toe.

Looking west at the landside slope.

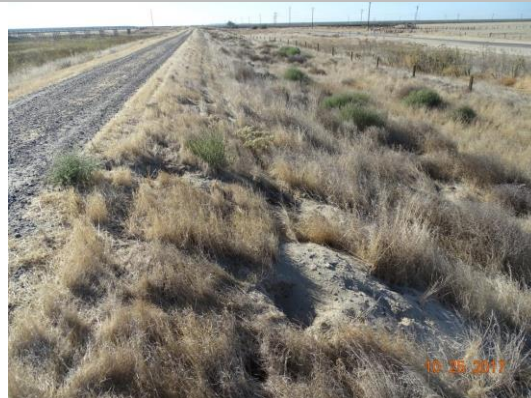
Photo 1 of 1 : SP\_2018\_NA0010\_137\_14\_20180307\_00007.jpg

LM Start	7.39	Rating **	U	Issue No.	14
LM End	7.53	Issue Type +	Ma	Location *	LS
Category	Earthen Levee			GPS Latitude/Longitude	
				Start	End
Item	Animal Control			36.874479 °	36.872503 °
				-120.319831 °	-120.319438 °
DWR ID	DWR_NA0010_18_f_2017_14				
Comment Code					
A3 : No rodents visible, but rodent burrows visible; need to backfill and compact or grout burrows.					
Inspector Comment					
Several rodent holes noted along landside slope in this area.

Looking south at the landside slope.

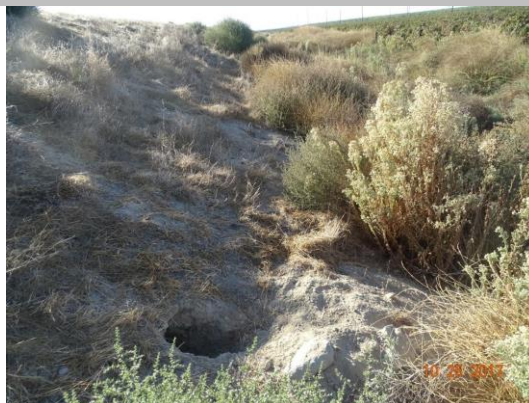
Photo 1 of 1 : SP\_2018\_NA0010\_137\_13\_20180307\_00006.jpg

LM Start	8.67	Rating **	U	Issue No.	13
LM End	8.67	Issue Type +	Ma	Location *	LS
Category	Earthen Levee			GPS Latitude/Longitude	
				Start	End
Item	Animal Control			36.856115 °	36.856115 °
				-120.316595 °	-120.316595 °
DWR ID	DWR_NA0010_18_f_2017_13				
Comment Code					
A3 : No rodents visible, but rodent burrows visible; need to backfill and compact or grout burrows.					
Inspector Comment

Looking south at the landside slope.

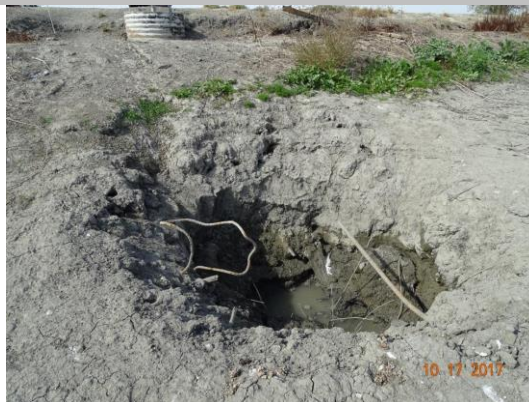
Photo 1 of 2 : SP\_2018\_NA0010\_138\_18\_20180307\_00016.jpg

LM Start	0.10	Rating **	U	Issue No.	18
LM End	0.10	Issue Type +	Ma	Location *	WS
Category	Earthen Levee			GPS Latitude/Longitude	
				Start	End
Item	Erosion / Bank Caving			37.207017 °	37.207017 °
				-120.696261 °	-120.696261 °
DWR ID	DWR_NA0010_22A_f_2017_18				
Comment Code					
E2 : Schedule repair of erosion site prior to the next inspection.					
Inspector Comment					
Sinkhole on waterside at pipe location.

Looking west at waterside sinkhole.

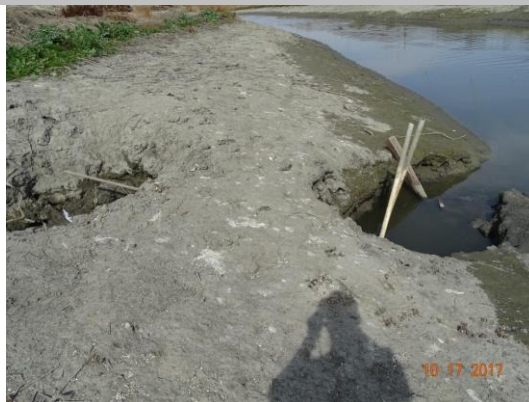
Photo 2 of 2 : SP\_2018\_NA0010\_138\_18\_20180307\_00017.jpg

Looking north at the waterside slope.

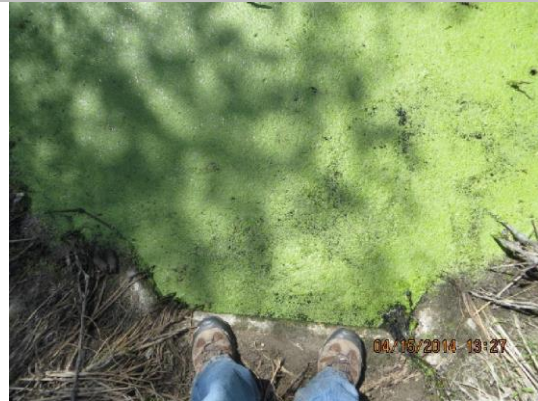
Photo 3 of 3 : UCIP\_SP\_2018\_49959\_61059.jpg

Comment Code						
Inspector Comment						
FS_ID:49959						
DS_ID:19933						
EP_NO: N/A						
Repair Type: Non-Urgent						
Crossing Status: Found						
UCIP Comments: 07/19/2016 Gate inside riser appears operable--riser lid damage. Crossing is not visible on LS due to dense vegetation. Recommend clearing dense vegetation along WS and LS slope and repairing riser cover. (DWR UCIP - omagana)04/15/2014 No actuator wheel on slide gate at WS shoulder. (DWR UCIP - omagana)						
FIELD_STRUCT_DESC: 24-inch corrugated metal gravity drainage pipe through the levee, 14.8 feet below the crown. Slide gate in a 36-inch corrugated metal pipe (CMP) riser on the waterside (WS) slope. Concrete U-shaped headwall on each end. [Additional Reference(s): DWR Levee Log, 2002. USACE San Joaquin O&M Manual 601.1, 1967, (HLM 0.10)].						
FS Date: 7/19/2016

Concrete headwall at LS toe.

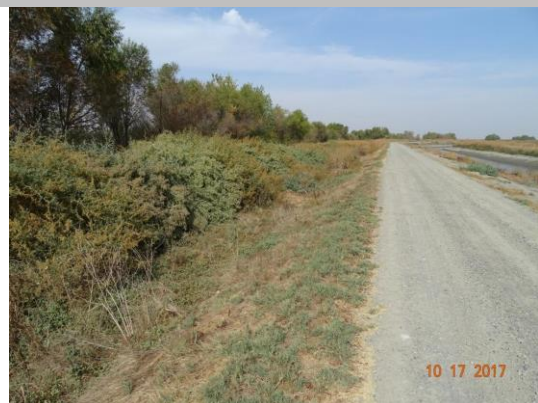
Photo 1 of 3 : SP\_2018\_NA0010\_138\_21\_20180307\_00018.jpg

LM Start	0.53	Rating **	U	Issue No.	21
LM End	0.85	Issue Type +	Ma	Location *	LS
Category	Earthen Levee			GPS Latitude/Longitude	
				Start	End
Item	Vegetation			37.213006 °	37.217593 °
				-120.698019 °	-120.697400 °
DWR ID	DWR_NA0010_22A_f_2014_21				
Comment Code					
V2 : Remove the wild growth other than native grasses from the levee slopes.					
Inspector Comment					
Dense vegetation on landside slope.

Looking northwest at the landside slope.

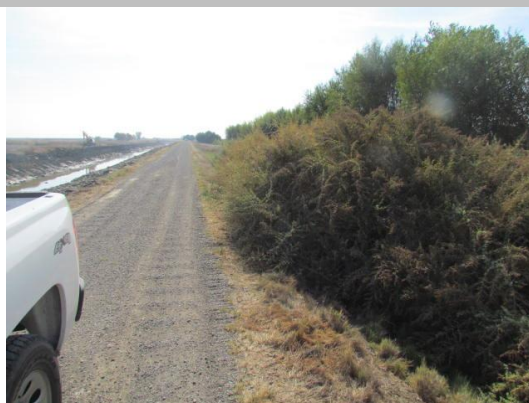
Photo 3 of 3 : SP\_2018\_NA0010\_138\_21\_20180307\_00020.jpg

Looking south at dense vegetation on landward slope. Spring 2015

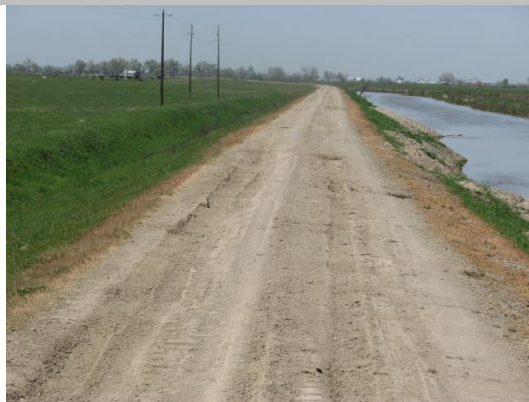
Photo 1 of 2 : SP\_2018\_NA0010\_138\_10\_20180411\_00035.jpg

LM Start	1.03	Rating **	M	Issue No.	10
LM End	5.09	Issue Type +	Ma	Location *	CR
Category	Earthen Levee			GPS Latitude/Longitude	
				Start	End
Item	Crown Surface / Depressions / Rutting			37.220040 °	37.267962 °
				-120.698181 °	-120.736909 °
DWR ID	DWR_NA0010_22A_s_2018_10				
Comment Code					
C2 : Repair depressions or ruts in the crown or slope.					
Inspector Comment					
Several pot holes and depressions along levee crown.

Looking upstream at rutting on levee crown within this section. (Spring 2018)

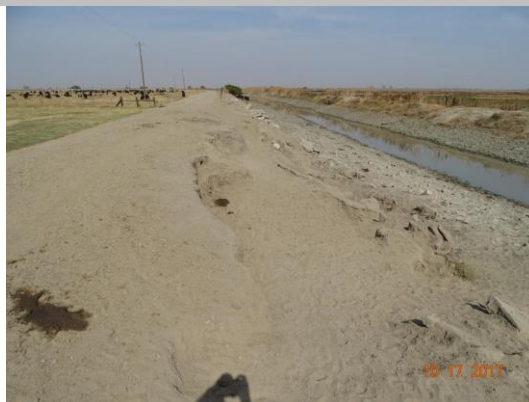
Photo 1 of 2 : SP\_2018\_NA0010\_138\_7\_20180307\_00005.jpg

LM Start	2.65	Rating **	U	Issue No.	7
LM End	2.65	Issue Type +	Ma	Location *	WS
Category	Earthen Levee			GPS Latitude/Longitude	
				Start	End
Item	Erosion / Bank Caving			37.242595 °	37.242595 °
				-120.706470 °	-120.706470 °
DWR ID	DWR_NA0010_22A_s_2017_7				
Comment Code					
E2 : Schedule repair of erosion site prior to the next inspection.					
Inspector Comment					
Erosion cutting into waterside shoulder.

Looking northwest at the waterside shoulder.

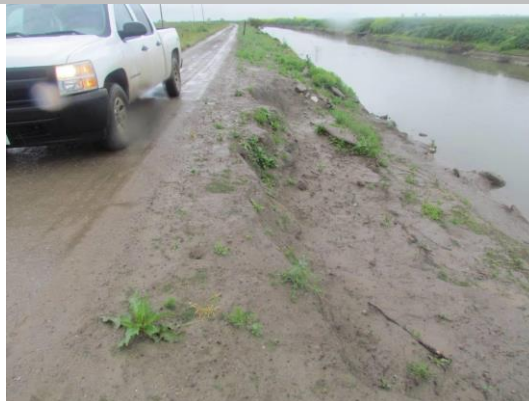
Photo 2 of 2 : SP\_2018\_NA0010\_138\_7\_20180307\_00006.jpg

LM Start	2.65	Rating **	U	Issue No.	7 (cont)	
LM End	2.65	Issue Type +	Ma	Location *	WS	
Category	Earthen Levee			GPS Latitude/Longitude		
				Start		End
Item	Erosion / Bank Caving			37.242595 °	37.242595 °	
				-120.706470 °	-120.706470 °	
DWR ID	DWR_NA0010_22A_s_2017_7					
Comment Code						
E2 : Schedule repair of erosion site prior to the next inspection.						
Inspector Comment						
Erosion cutting into waterside shoulder.

Looking downstream at erosion on waterward shoulder and slope.

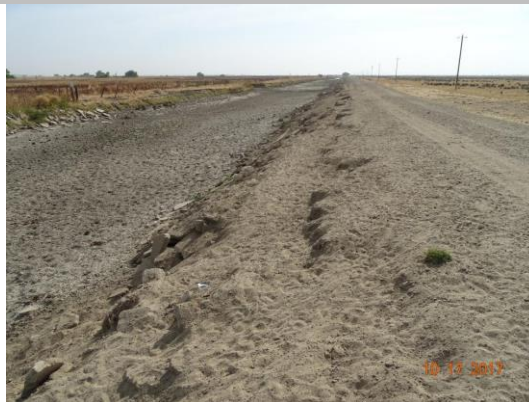
Photo 1 of 2 : SP\_2018\_NA0010\_138\_9\_20180307\_00009.jpg

LM Start	3.64	Rating **	U	Issue No.	9
LM End	3.69	Issue Type +	Ma	Location *	WS
Category	Earthen Levee			GPS Latitude/Longitude	
				Start	End
Item	Erosion / Bank Caving			37.253362 °	37.253862 °
				-120.717873 °	-120.718507 °
DWR ID	DWR_NA0010_22A_f_2016_9				
Comment Code					
E1 : Note and monitor erosion site.					
Inspector Comment					
Several erosions or levee damage caused by animal traffice within this section.

Looking southeast at the waterside slope.

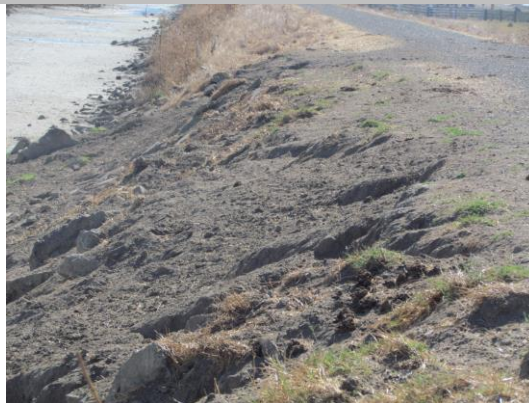
Photo 2 of 2 : SP\_2018\_NA0010\_138\_9\_20180307\_00010.jpg

LM Start	3.64	Rating **	U	Issue No.	9 (cont)	
LM End	3.69	Issue Type +	Ma	Location *	WS	
Category	Earthen Levee			GPS Latitude/Longitude		
				Start		End
Item	Erosion / Bank Caving			37.253362 °	37.253862 °	
				-120.717873 °	-120.718507 °	
DWR ID	DWR_NA0010_22A_f _ 2016_9					
Comment Code						
E1 : Note and monitor erosion site.						
Inspector Comment						
Several erosions or levee damage caused by animal traffice within this section.

Looking downstream at animal erosion on waterward slope.

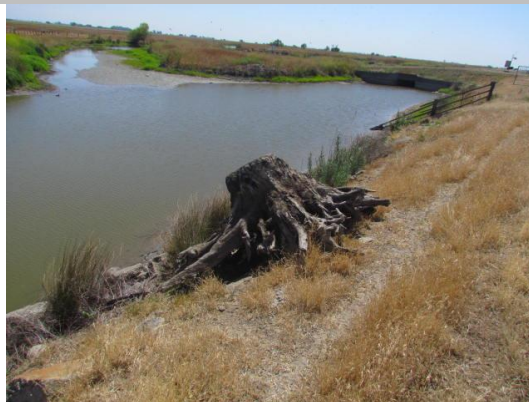
Photo 1 of 1 : SP\_2018\_NA0010\_138\_259\_20180307\_00022.jpg

LM Start	3.80	Rating **	M	Issue No.	259
LM End	3.80	Issue Type +	Ma	Location *	WS
Category	Earthen Levee			GPS Latitude/Longitude	
				Start	End
Item	Encroachments			37.255067 °	37.255067 °
				-120.719910 °	-120.719910 °
DWR ID	DWR_NA0010_22A_s_2015_259				
Comment Code					
TR : Tree or limb					
Inspector Comment					
Dead tree stump on waterside slope.

Looking east at dead stump on waterward slope.

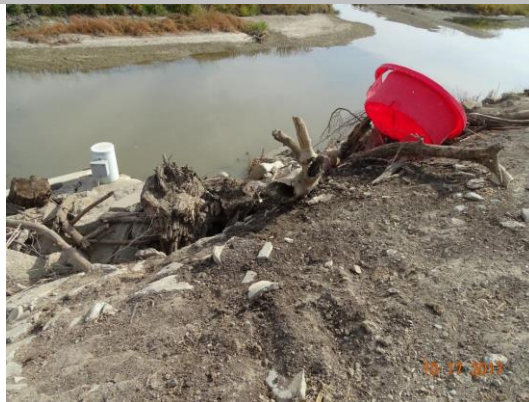
Photo 1 of 1 : SP\_2018\_NA0010\_138\_13\_20180307\_00012.jpg

LM Start	3.81	Rating **	M	Issue No.	13
LM End	3.81	Issue Type +	Ma	Location *	WS
Category	Earthen Levee			GPS Latitude/Longitude	
				Start	End
Item	Encroachments			37.255199 °	37.255199 °
				-120.720094 °	-120.720094 °
DWR ID	DWR_NA0010_22A_f_2017_13				
Comment Code					
TR : Tree or limb					
Inspector Comment

Looking northeast at the waterside slope.

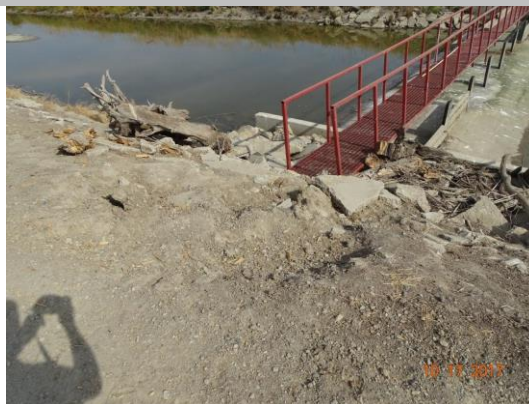
Photo 1 of 1 : SP\_2018\_NA0010\_138\_14\_20180307\_00013.jpg

LM Start	3.82	Rating **	A/W	Issue No.	14
LM End	3.82	Issue Type +	Ma	Location *	WS
Category	Earthen Levee			GPS Latitude/Longitude	
				Start	End
Item	Slope Stability			37.255239 °	37.255239 °
				-120.720142 °	-120.720142 °
DWR ID	DWR_NA0010_22A_f_2017_14				
Comment Code					
S1 : Repair slope instability.					
Inspector Comment

Looking northeast at the waterside slope.

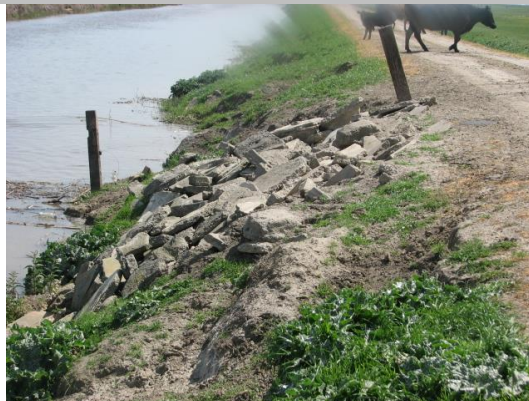
Photo 1 of 4 : SP\_2018\_NA0010\_138\_8\_20180411\_00036.jpg

LM Start	4.87	Rating **	A/W	Issue No.	8
LM End	4.87	Issue Type +	Ma	Location *	WS
Category	Earthen Levee			GPS Latitude/Longitude	
				Start	End
Item	Slope Stability			37.265813 °	37.265813 °
				-120.733748 °	-120.733748 °
DWR ID	DWR_NA0010_22A_f_2016_8				
Comment Code					
S1 : Repair slope instability.					
Inspector Comment					
Levee damage caused by animal traffic. Several site repaired with broken concrete. But other sites still need repairing.

Looking downstream at repaired site with concrete rubble on waterward slope and shoulder. (Spring 2018)

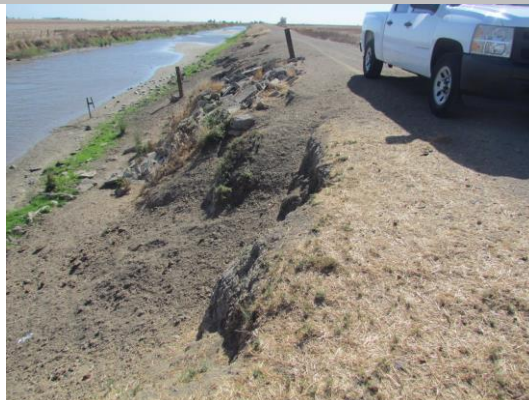
Photo 2 of 4 : SP\_2018\_NA0010\_138\_8\_20180307\_00008.jpg

Looking downstream at animal erosion on waterward slope.

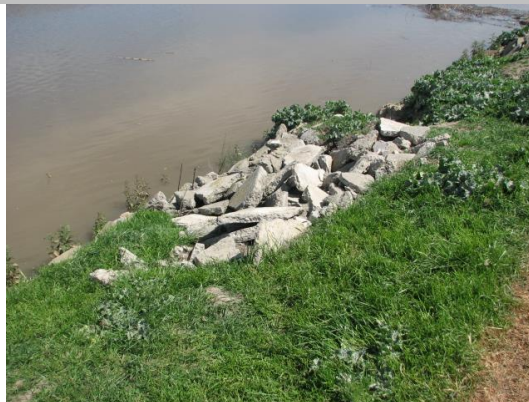
Photo 3 of 4 : SP\_2018\_NA0010\_138\_8\_20180411\_00037.jpg

Looking downstream at repaired site with concrete rubble on waterward slope. (Spring 2018)

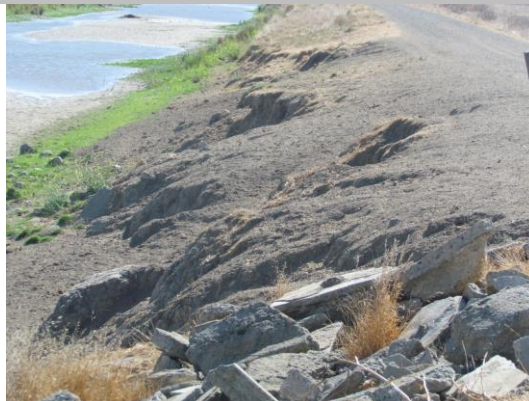
Photo 4 of 4 : SP\_2018\_NA0010\_138\_8\_20180307\_00007.jpg

LM Start	4.87	Rating **	A/W	Issue No.	8 (cont)	
LM End	4.87	Issue Type +	Ma	Location *	WS	
Category	Earthen Levee			GPS Latitude/Longitude		
				Start		End
Item	Slope Stability			37.265813 °		37.265813 °
				-120.733748 °		-120.733748 °
DWR ID	DWR_NA0010_22A_f_2016_8					
Comment Code						
S1 : Repair slope instability.						
Inspector Comment						
Levee damage caused by animal traffic. Several site repaired with broken concrete. But other sites still need repairing.

Looking downstream at animal erosion on waterward slope.

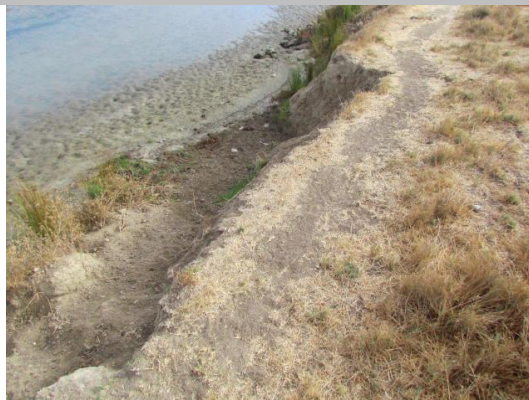
Photo 1 of 2 : SP\_2018\_NA0010\_138\_4\_20180307\_00001.jpg

LM Start	5.05	Rating **	M	Issue No.	4
LM End	5.05	Issue Type +	Ma	Location *	WS
Category	Earthen Levee			GPS Latitude/Longitude	
				Start	End
Item	Erosion / Bank Caving			37.267516 °	37.267516 °
				-120.736401 °	-120.736401 °
DWR ID	DWR_NA0010_22A_f_2013_4				
Comment Code					
E2 : Schedule repair of erosion site prior to the next inspection.					
Inspector Comment					
Erosion caused by animal traffic.

Looking southeast at livestock erosion on waterward toe.

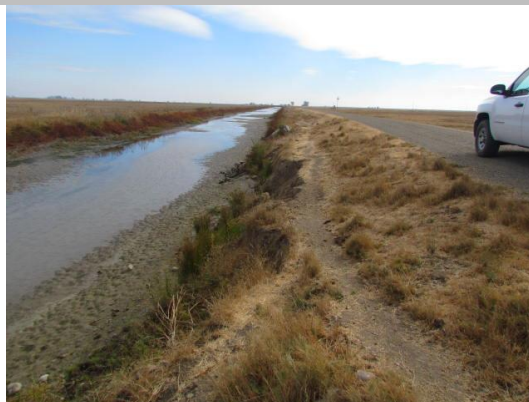
Photo 2 of 2 : SP\_2018\_NA0010\_138\_4\_20180307\_00002.jpg

Looking southeast at livestock erosion on waterward toe.

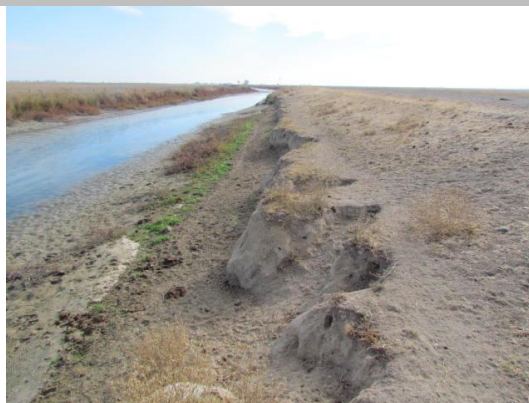
Photo 1 of 2 : SP\_2018\_NA0010\_138\_6\_20180307\_00003.jpg

LM Start	5.12	Rating **	M	Issue No.	6
LM End	5.20	Issue Type +	Ma	Location *	WS
Category	Earthen Levee			GPS Latitude/Longitude	
				Start	End
Item	Slope Stability			37.268236°	37.269124°
				-120.737210°	-120.738200°
DWR ID	DWR_NA0010_22A_s_2012_6				
Comment Code					
S2 : Repair the levee slope damaged by foot traffic and prevent access where possible.					
Inspector Comment					
Slope damage caused by livestock on waterside toe.

Looking southeast at livestock erosion on waterward toe.

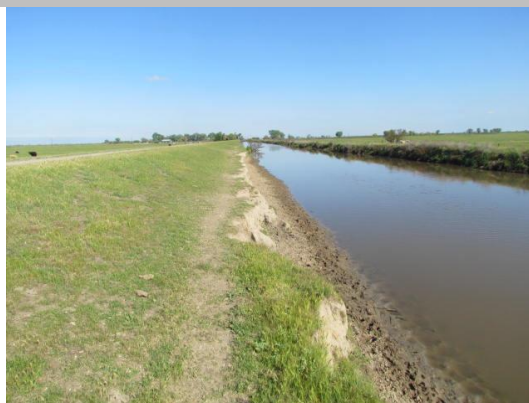
Photo 2 of 2 : SP\_2018\_NA0010\_138\_6\_20180307\_00004.jpg

Looking northwest at livestock erosion along waterside slope and toe.

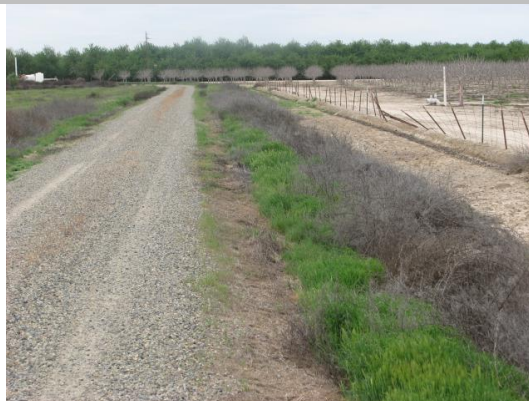
Photo 1 of 1 : SP\_2018\_NA0010\_139\_30\_20180411\_00055.jpg

LM Start	0.00	Rating **	M	Issue No.	30
LM End	10.24	Issue Type +	Ma	Location *	LS
Category	Earthen Levee			GPS Latitude/Longitude	
				Start	End
Item	Vegetation			36.774437 °	36.814780 °
				-120.283750 °	-120.168792 °
DWR ID	DWR_NA0010_23_s_2018_30				
Comment Code					
V1 : Control annual grass and weeds on the levee slopes and easements.					
Inspector Comment

Looking upstream at typical view of landward slope. (Spring 2018)

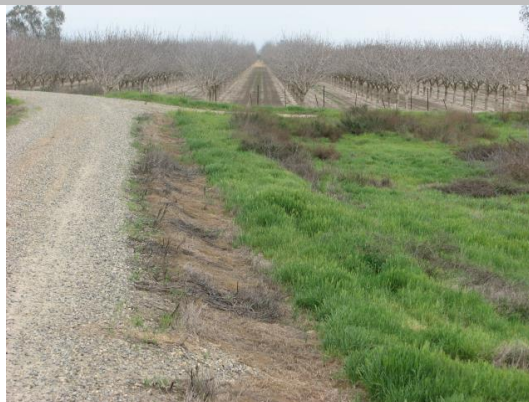
Photo 1 of 1 : SP\_2018\_NA0010\_139\_33\_20180411\_00056.jpg

LM Start	0.00	Rating **	M	Issue No.	33
LM End	10.24	Issue Type +	Ma	Location *	WS
Category	Earthen Levee			GPS Latitude/Longitude	
				Start	End
Item	Vegetation			36.774437 °	36.814783 °
				-120.283750 °	-120.168789 °
DWR ID	DWR_NA0010_23_s_2018_33				
Comment Code					
V1 : Control annual grass and weeds on the levee slopes and easements.					
Inspector Comment

Looking upstream at typical view of waterward slope. (Spring 2018)

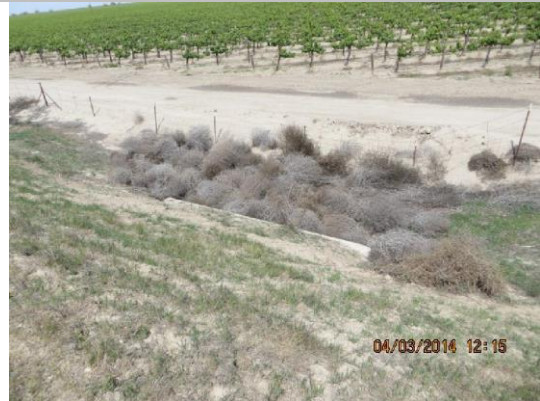
Photo 3 of 3 : UCIP\_SP\_2018\_39537\_59861.jpg

Comment Code						
Inspector Comment						
FS_ID:39537						
DS_ID:19945						
EP_NO: N/A						
Repair Type: Non-Urgent						
Crossing Status: Found						
UCIP Comments: Excessive vegetation at inlet--recommend clearing.						
FIELD_STRUCT_DESC: 30-inch by 30-inch square reinforced concrete						
box gravity drainage culvert through the levee, 13 feet below the crown.						
Flap gate on the waterside (WS) end. Concrete headwall on the						
landside (LS) end. Concrete U-shaped headwall on the WS end. (Plans						
to construct a new discharge structure and to rehabilitate one existing						
diversion structure to return intercepted seepage to the San Joaquin						
River authorized under Permit No. 13085, 1981 - Diener, Dry River						
Farms). [Additional Reference(s): DWR Levee Log, 2002. USACE San						
Joaquin O&M Manual 601.1, 1967, (HLM 0.21)].						
FS Date: 4/3/2014

Concrete headwall at LS toe. Excess vegetation buildup at inlet.

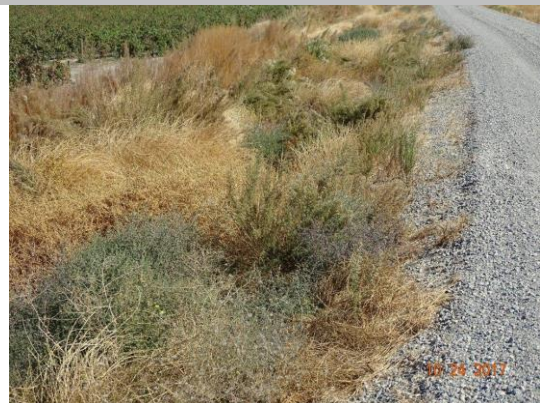
Photo 1 of 1 : SP\_2018\_NA0010\_139\_27\_20180307\_00023.jpg

LM Start	1.07	Rating **	U	Issue No.	27
LM End	1.15	Issue Type +	Ma	Location *	LS
Category	Earthen Levee			GPS Latitude/Longitude	
				Start	End
Item	Vegetation			36.772726 °	36.772884 °
				-120.267276 °	-120.265736 °
DWR ID	DWR_NA0010_23_f_2017_27				
Comment Code					
V2 : Remove the wild growth other than native grasses from the levee slopes.					
Inspector Comment					
LMA mowed at toe of levee, but due to dense vegetation unable to see landside slope with limited visibility of toe.

Looking east at landside slope.

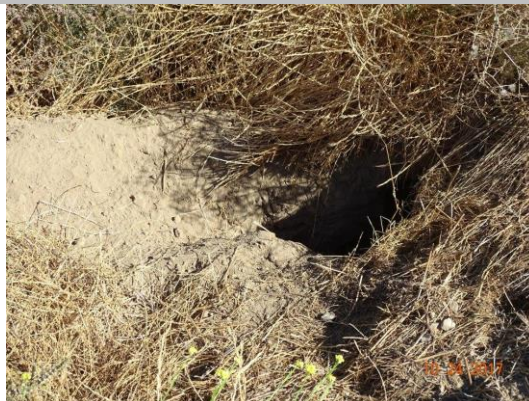
Photo 1 of 1 : SP\_2018\_NA0010\_139\_26\_20180307\_00022.jpg

LM Start	1.09	Rating **	U	Issue No.	26
LM End	1.09	Issue Type +	Ma	Location *	LS
Category	Earthen Levee			GPS Latitude/Longitude	
				Start	End
Item	Animal Control			36.772743 °	36.772743 °
				-120.266800 °	-120.266800 °
DWR ID	DWR_NA0010_23_f_2017_26				
Comment Code					
A3 : No rodents visible, but rodent burrows visible; need to backfill and compact or grout burrows.					
Inspector Comment					
Need to repair large rodent hole

Looking at the landside slope.

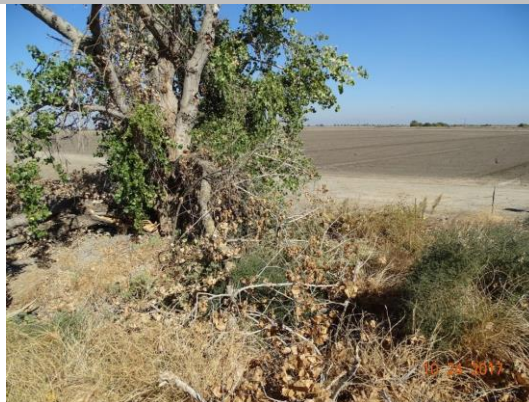
Photo 1 of 1 : SP\_2018\_NA0010\_139\_28\_20180307\_00024.jpg

LM Start	1.52	Rating **	M	Issue No.	28
LM End	1.52	Issue Type +	Ma	Location *	LS
Category	Earthen Levee			GPS Latitude/Longitude	
				Start	End
Item	Encroachments			36.772066 °	36.772066 °
				-120.259545 °	-120.259545 °
DWR ID	DWR_NA0010_23_f_2017_28				
Comment Code					
TR : Tree or limb					
Inspector Comment					
Downed tree limbs on landside slope.

Looking north at landside slope.

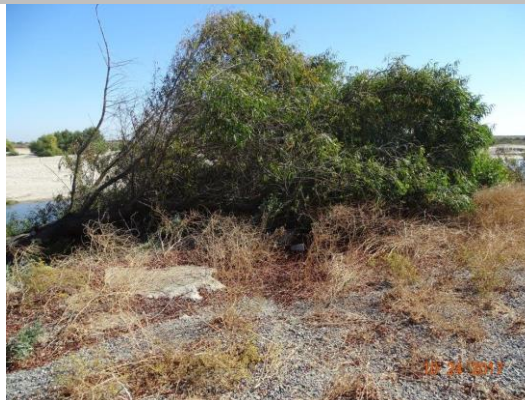
Photo 1 of 1 : SP\_2018\_NA0010\_139\_1\_20180307\_00001.jpg

LM Start	1.91	Rating **	U	Issue No.	1
LM End	1.91	Issue Type +	Ma	Location *	WS
Category	Earthen Levee			GPS Latitude/Longitude	
				Start	End
Item	Encroachments			36.772943 °	36.772943 °
				-120.253511 °	-120.253511 °
DWR ID	DWR_NA0010_23_s_2015_1				
Comment Code					
TR : Tree or limb					
Inspector Comment					
Downed tree on waterside slope.

Looking east at waterside slope.

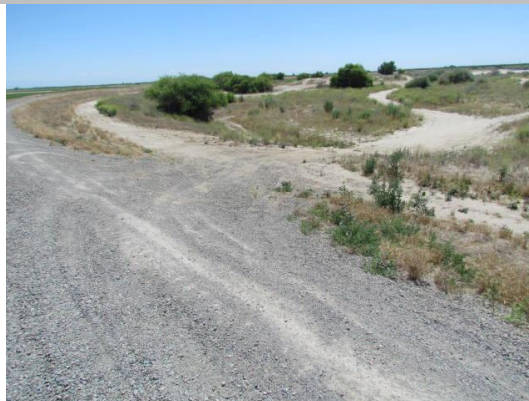
Photo 1 of 1 : SP\_2018\_NA0010\_139\_16\_20180307\_00017.jpg

LM Start	2.12	Rating **	M	Issue No.	16
LM End	2.12	Issue Type +	Ma	Location *	WS
Category	Earthen Levee			GPS Latitude/Longitude	
				Start	End
Item	Slope Stability			36.775507 °	36.775507 °
				-120.251672 °	-120.251670 °
DWR ID	DWR_NA0010_23_s _ 2013_16				
Comment Code					
S3 : Repair the levee slope damaged by vehicle traffic and prevent access where possible.					
Inspector Comment					
Several damaged sites within this reach. Damage caused by vehicle traffic. At. LM. 2.12, 2.21, 2.37, 2.41, & 2.47

Looking west at one of several slope damaged cause by vehicle traffic.

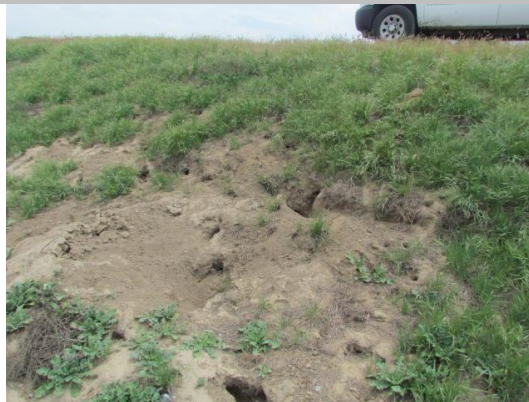
Photo 1 of 1 : SP\_2018\_NA0010\_139\_5\_20180307\_00006.jpg

LM Start	5.68	Rating **	U	Issue No.	5
LM End	5.68	Issue Type +	Ma	Location *	LS
Category	Earthen Levee			GPS Latitude/Longitude	
				Start	End
Item	Animal Control			36.791981 °	36.791981 °
				-120.206274 °	-120.206274 °
DWR ID	DWR_NA0010_23_s_2012_5				
Comment Code					
A1 : Exterminate rodents and backfill and compact or grout burrows.					
Inspector Comment					
Several large rodent holes in this area.

Looking at several rodent holes on landside slope.

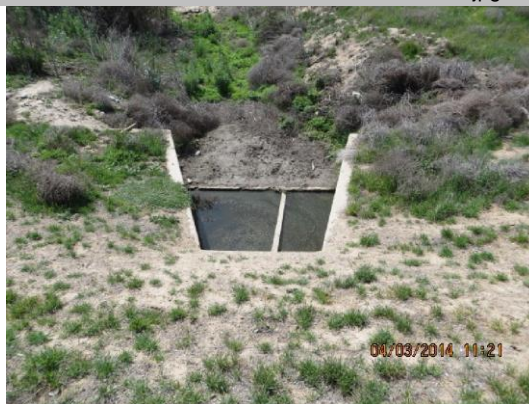
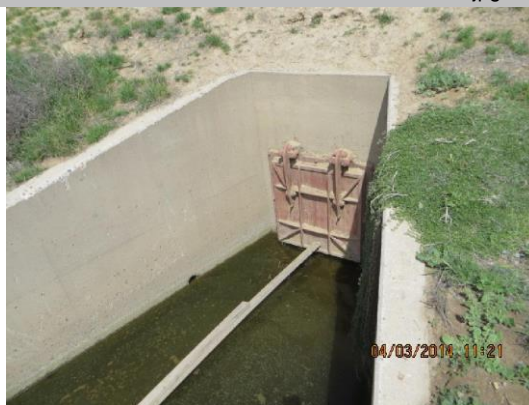
FS\_ID:39542  
DS\_ID:19954  
EP\_NO: N/A  
Repair Type: Non-Urgent  
Crossing Status: Found  
UCIP Comments: Dense vegetation limits the inspector's visibility to identify signs of pipe failure (leaks) along the landward slope. Recommend removing vegetation along pipe alignment to conduct proper inspection of structure.  
FIELD\_STRUCT\_DESC: 36-inch by 36-inch square reinforced concrete box gravity drainage culvert through the levee, 9 feet below the crown. Flap gate on the waterside (WS) end. Concrete U-shaped headwall on each end. 5-foot-long cobble revetted outlet channel. [Additional Reference(s): DWR Levee Log, 2002. USACE San Joaquin O&M Manual 601.1, 1967, (HLM 5.71)].  
FS Date: 4/3/2014

Concrete headwall on WS toe.

Flapgate on Concrete headwall on WS toe.

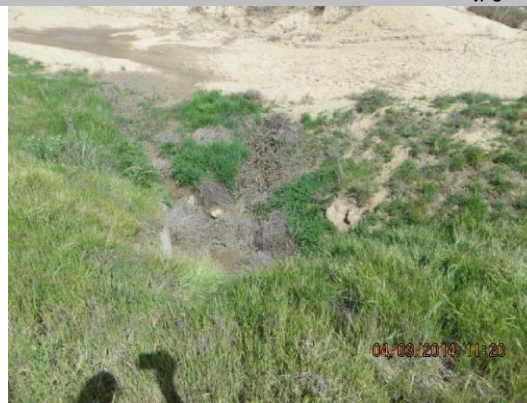
Photo 3 of 3 : UCIP\_SP\_2018\_39542\_59831.jpg

Comment Code						
Inspector Comment						
FS_ID:39542 DS_ID:19954 EP_NO: N/A Repair Type: Non-Urgent Crossing Status: Found UCIP Comments: Dense vegetation limits the inspector's visibility to identify signs of pipe failure (leaks) along the landward slope. Recommend removing vegetation along pipe alignment to conduct proper inspection of structure. FIELD_STRUCT_DESC: 36-inch by 36-inch square reinforced concrete box gravity drainage culvert through the levee, 9 feet below the crown. Flap gate on the waterside (WS) end. Concrete U-shaped headwall on each end. 5-foot-long cobble revetted outlet channel. [Additional Reference(s): DWR Levee Log, 2002. USACE San Joaquin O&M Manual 601.1, 1967, (HLM 5.71)]. FS Date: 4/3/2014

Concrete headwall at LS toe.

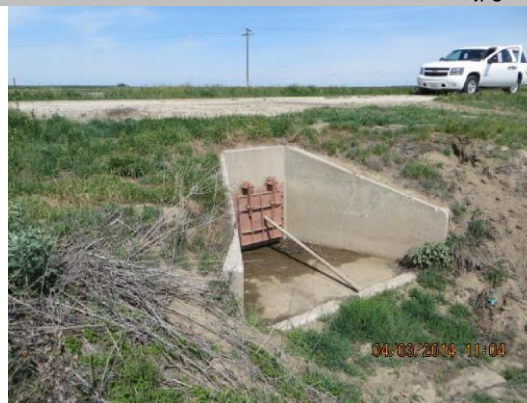
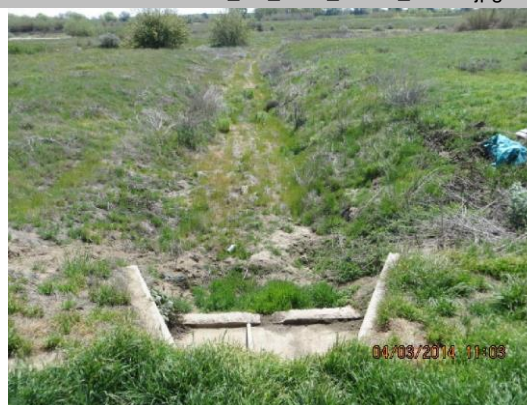
FS\_ID:39544  
DS\_ID:19940  
EP\_NO: N/A  
Repair Type: Non-Urgent  
Crossing Status: Found  
UCIP Comments: Some sediment buildup at inlet at LS toe. Also dense vegetation limits the inspector's visibility to identify signs of pipe failure (leaks) along the landward slope. Recommend removing vegetation along pipe alignment to conduct proper inspection of structure.  
FIELD\_STRUCT\_DESC: 30-inch by 30-inch square reinforced concrete box gravity drainage culvert through the levee, 5.2 feet below the crown. Flap gate on the waterside (WS) end. Concrete headwall on the landside (LS) end. Concrete U-shaped headwall on the WS end.  
[Additional Reference(s): DWR Levee Log, 2002. USACE San Joaquin O&M Manual 601.1, 1967, (HLM 8.33)].  
FS Date: 4/3/2014

Flapgate on WS toe.

concrete headwall at drainage ditch on WS toe.

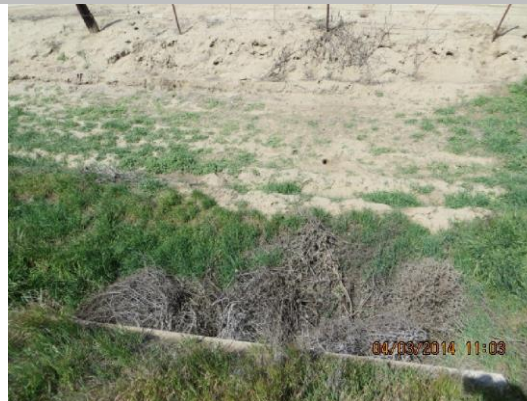
Photo 3 of 3 : UCIP\_SP\_2018\_39544\_59822.jpg

Comment Code					
Inspector Comment					
FS_ID:39544					
DS_ID:19940					
EP_NO: N/A					
Repair Type: Non-Urgent					
Crossing Status: Found					
UCIP Comments: Some sediment buildup at inlet at LS toe. Also dense vegetation limits the inspector's visibility to identify signs of pipe failure (leaks) along the landward slope. Recommend removing vegetation along pipe alignment to conduct proper inspection of structure.					
FIELD_STRUCT_DESC: 30-inch by 30-inch square reinforced concrete box gravity drainage culvert through the levee, 5.2 feet below the crown. Flap gate on the waterside (WS) end. Concrete headwall on the landside (LS) end. Concrete U-shaped headwall on the WS end.					
[Additional Reference(s): DWR Levee Log, 2002. USACE San Joaquin O&M Manual 601.1, 1967, (HLM 8.33)].					
FS Date: 4/3/2014

Concrete headwall on LS toe.

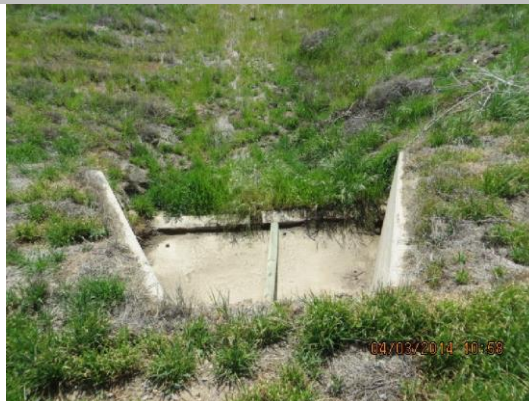
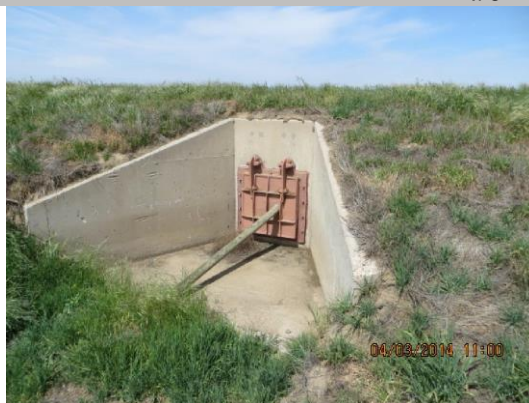
Comment Code					
Inspector Comment					
FS_ID:39545					
DS_ID:19941					
EP_NO: N/A					
Repair Type: Non-Urgent					
Crossing Status: Found					
UCIP Comments: Dense vegetation limits the inspector's visibility to identify signs of pipe failure (leaks) along the landward slope.					
Recommend removing vegetation along pipe alignment to conduct proper inspection of structure.					
FIELD_STRUCT_DESC: 30-inch by 30-inch square reinforced concrete box gravity drainage culvert through the levee, 5.6 feet below the crown.					
Flap gate on the waterside (WS) end. Concrete headwall on the landside (LS) end. Concrete U-shaped headwall on the WS end.					
[Additional Reference(s): DWR Levee Log, 2002. USACE San Joaquin O&M Manual 601.1, 1967, (HLM 8.54)].					
FS Date: 4/3/2014

Concrete headwall on WS toe.

Flapgate on Concrete headwall at WS toe.

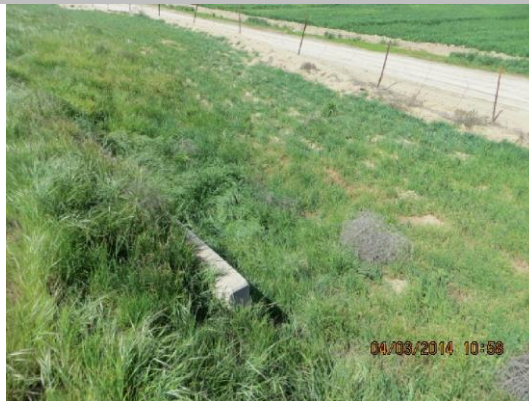
Photo 3 of 3 : UCIP\_SP\_2018\_39545\_59818.jpg

Comment Code						
Inspector Comment						
FS_ID:39545						
DS_ID:19941						
EP_NO: N/A						
Repair Type: Non-Urgent						
Crossing Status: Found						
UCIP Comments: Dense vegetation limits the inspector's visibility to identify signs of pipe failure (leaks) along the landward slope.						
Recommend removing vegetation along pipe alignment to conduct proper inspection of structure.						
FIELD_STRUCT_DESC: 30-inch by 30-inch square reinforced concrete box gravity drainage culvert through the levee, 5.6 feet below the crown.						
Flap gate on the waterside (WS) end. Concrete headwall on the landside (LS) end. Concrete U-shaped headwall on the WS end.						
[Additional Reference(s): DWR Levee Log, 2002. USACE San Joaquin O&M Manual 601.1, 1967, (HLM 8.54)].						
FS Date: 4/3/2014

Concrete headwall on LS toe.

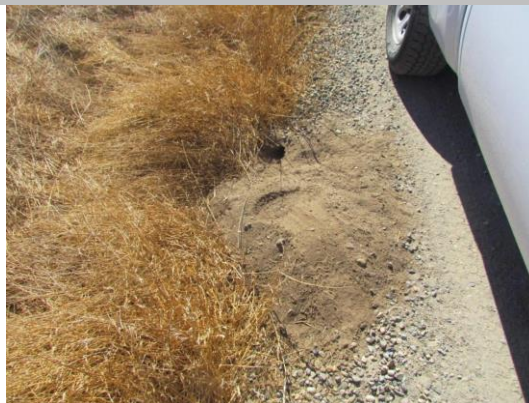
Photo 1 of 1 : SP\_2018\_NA0010\_139\_25\_20180307\_00021.jpg

LM Start	8.97	Rating **	U	Issue No.	25
LM End	8.97	Issue Type +	Ma	Location *	WS
Category	Earthen Levee			GPS Latitude/Longitude	
				Start	End
Item	Animal Control			36.799606 °	36.799606 °
				-120.175395 °	-120.175395 °
DWR ID	DWR_NA0010_23_f_2016_25				
Comment Code					
A3 : No rodents visible, but rodent burrows visible; need to backfill and compact or grout burrows.					
Inspector Comment					
Rodent holes on waterside shoulder.

Looking at typical view of rodent hole on waterward shoulder.

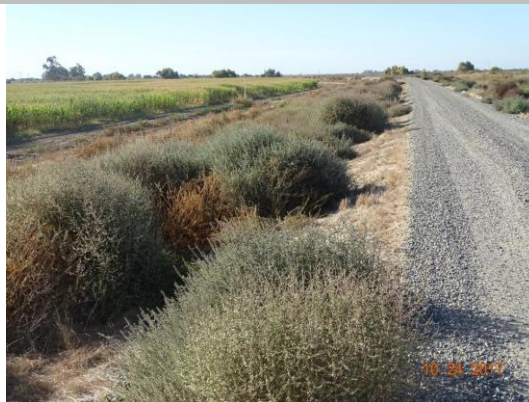
Photo 1 of 1 : SP\_2018\_NA0010\_140\_19\_20180307\_00008.jpg

LM Start	2.07	Rating **	U	Issue No.	19
LM End	2.13	Issue Type +	Ma	Location *	LS
Category	Earthen Levee			GPS Latitude/Longitude	
				Start	End
Item	Vegetation			36.770778 °	36.770293 °
				-120.260848 °	-120.259840 °
DWR ID	DWR_NA0010_24_f_2017_19				
Comment Code					
V2 : Remove the wild growth other than native grasses from the levee slopes.					
Inspector Comment					
LMA mowed landside toe, however dense vegetation on slope limits visibility.

Looking northwest at landside slope.

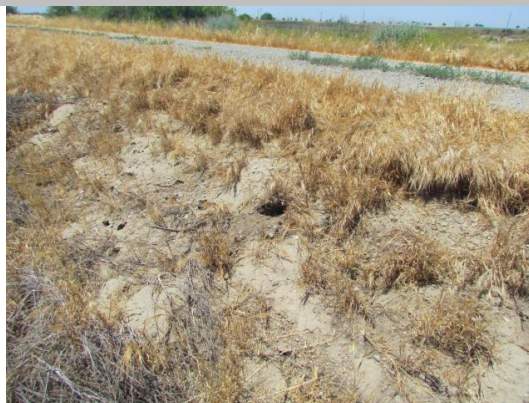
Photo 1 of 1 : SP\_2018\_NA0010\_140\_7\_20180307\_00004.jpg

LM Start	3.46	Rating **	M	Issue No.	7
LM End	3.46	Issue Type +	Ma	Location *	LS
Category	Earthen Levee			GPS Latitude/Longitude	
				Start	End
Item	Animal Control			36.769345 °	36.769345 °
				-120.238370 °	-120.238370 °
DWR ID	DWR_NA0010_24_s_2012_7				
Comment Code					
A3 : No rodents visible, but rodent burrows visible; need to backfill and compact or grout burrows.					
Inspector Comment					
One of several rodent holes on landside slope.

Looking east at one of several rodent holes on landward slope.

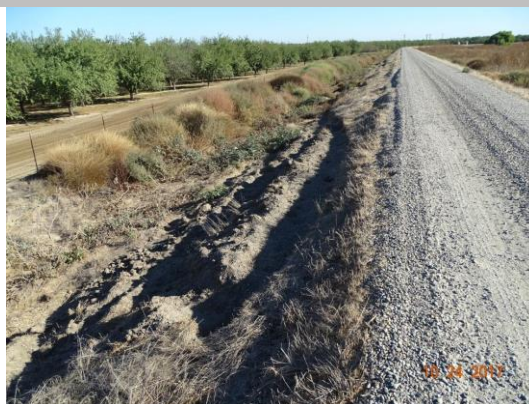
Photo 1 of 1 : SP\_2018\_NA0010\_140\_17\_20180307\_00007.jpg

LM Start	4.27	Rating **	M	Issue No.	17
LM End	4.27	Issue Type +	Ma	Location *	LS
Category	Earthen Levee			GPS Latitude/Longitude	
				Start	End
Item	Slope Stability			36.772003 °	36.772003 °
				-120.230075 °	-120.230075 °
DWR ID	DWR_NA0010_24_f_2017_17				
Comment Code					
S3 : Repair the levee slope damaged by vehicle traffic and prevent access where possible.					
Inspector Comment

Looking southeast at the landside slope.
