**Flood Control Project Maintenance  
Levee Inspections**

## Maintenance Issue Types Only, Levee Inspection Report By Mile - Spring 2018

### Lower San Joaquin Levee District

Waterway	Bank	Unit Miles	Inspection Start/End	Inspector
Unit No. 01 San Joaquin River	Right	22.52	04/04/2018 04/16/2018	Richard Willoughby

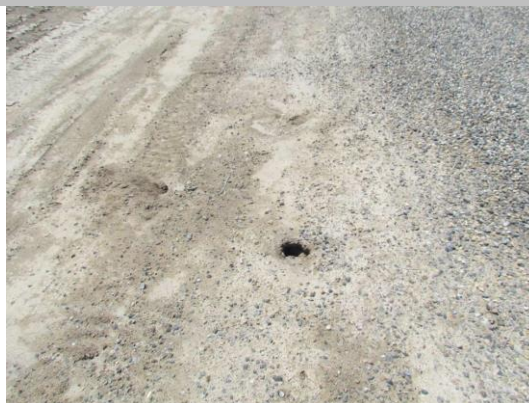
Photo 2 of 2 : SP\_2018\_NA0010\_140\_14\_20180307\_00006.jpg

LM Start	6.35	Rating **	M	Issue No.	14 (cont)	
LM End	6.35	Issue Type +	Ma	Location *	LS	
Category	Earthen Levee			GPS Latitude/Longitude		
				Start		End
Item	Animal Control			36.788225 °		36.788225 °
				-120.209357 °		-120.209357 °
DWR ID	DWR_NA0010_24_s_2017_14					
Comment Code						
A3 : No rodents visible, but rodent burrows visible; need to backfill and compact or grout burrows.						
Inspector Comment						
Several rodent holes on levee landside shoulder and slope.

Looking at typical view of rodent holes within this section on landward shoulder and slope.

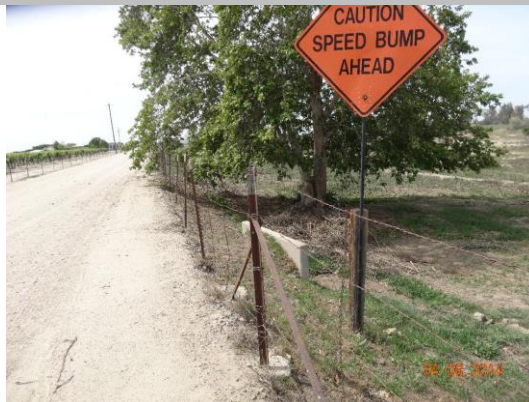
Photo 1 of 2 : UCIP\_SP\_2018\_33272\_60121.jpg

LM Start	8.33	Rating **	M	Issue No.	273
LM End	8.33	Issue Type +	Ma	Location *	
Category	Supplemental			GPS Latitude/Longitude	
				Start	End
Item	DWR UCIP LMA Responsibility			36.778084 °	36.778084 °
				-120.184454 °	-120.184454 °
DWR ID					
Comment Code					
Inspector Comment					
FS_ID:33272					
DS_ID:19960					
EP_NO: N/A					
Repair Type: Non-Urgent					
Crossing Status: Found					
UCIP Comments: Barbed wire along levee shoulder--no access. Need to confirm crossing size and condition of crossing.					
FIELD_STRUCT_DESC: 12-inch reinforced concrete gravity drainage pipe through the levee, 3 feet below the crown. Flap gate on the waterside (WS) end. Concrete headwall on the WS end. [Additional Reference(s): DWR Levee Log, 2002. USACE San Joaquin O&M Manual 601.1, 1967, (HLM 8.32)].					
FS Date: 4/8/2014

View of waterward side.

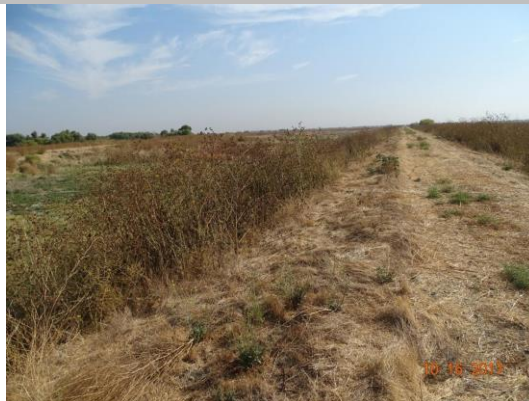
Photo 1 of 2 : SP\_2018\_NA0010\_141\_7\_20180307\_00001.jpg

LM Start	0.00	Rating **	U	Issue No.	7
LM End	1.00	Issue Type +	Ma	Location *	LS
Category	Earthen Levee			GPS Latitude/Longitude	
				Start	End
Item	Vegetation			37.296261 °	37.281769 °
				-120.880678 °	-120.880745 °
DWR ID	DWR_NA0010_25_f_2015_7				
Comment Code					
V2 : Remove the wild growth other than native grasses from the levee slopes.					
Inspector Comment

Looking south at the landside slope.

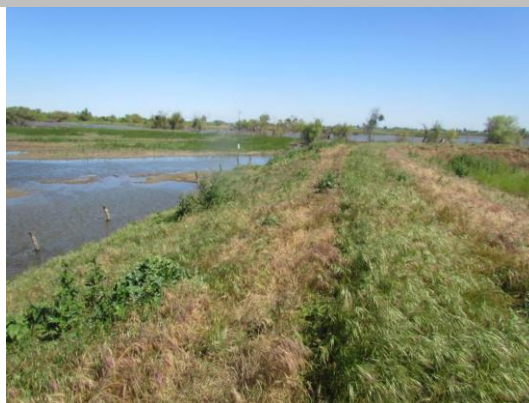
Photo 2 of 2 : SP\_2018\_NA0010\_141\_7\_20180307\_00002.jpg

LM Start	<b>0.00</b>	Rating **	U	Issue No.	<b>7 (cont)</b>
LM End	<b>1.00</b>	Issue Type +	Ma	Location *	LS

Looking at typical view of landward slope.

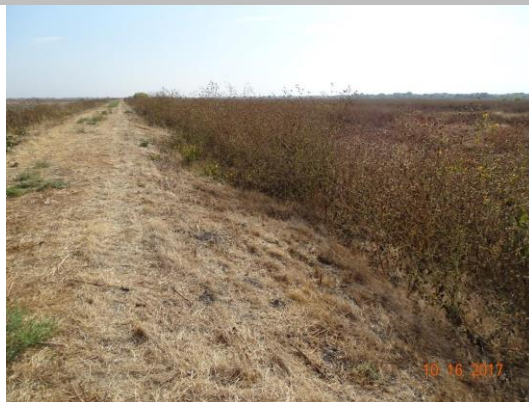
Photo 1 of 2 : SP\_2018\_NA0010\_141\_9\_20180307\_00005.jpg

LM Start	0.00	Rating **	M	Issue No.	9
LM End	1.00	Issue Type +	Ma	Location *	WS
Category	Earthen Levee			GPS Latitude/Longitude	
				Start	End
Item	Vegetation			37.296261 °	37.281768 °
				-120.880678 °	-120.880745 °
DWR ID	DWR_NA0010_25_f_2015_9				
Comment Code					
V2 : Remove the wild growth other than native grasses from the levee slopes.					
Inspector Comment

Looking south at the waterside slope.

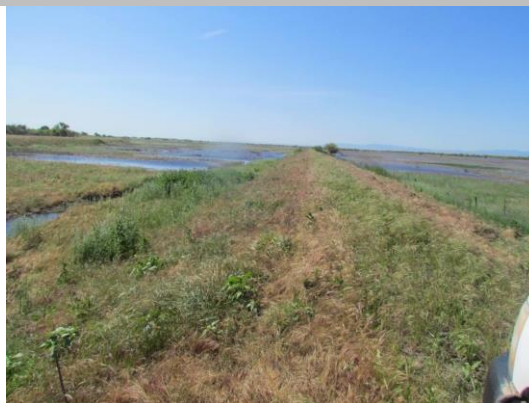
Photo 2 of 2 : SP\_2018\_NA0010\_141\_9\_20180307\_00006.jpg

LM Start	0.00	Rating **	M	Issue No.	9 (cont)	
LM End	1.00	Issue Type +	Ma	Location *	WS	
Category	Earthen Levee			GPS Latitude/Longitude		
				Start		End
Item	Vegetation			37.296261 °		37.281768 °
				-120.880678 °		-120.880745 °
DWR ID	DWR_NA0010_25_f_2015_9					
Comment Code						
V2 : Remove the wild growth other than native grasses from the levee slopes.						
Inspector Comment

Looking typical view of waterward slope.

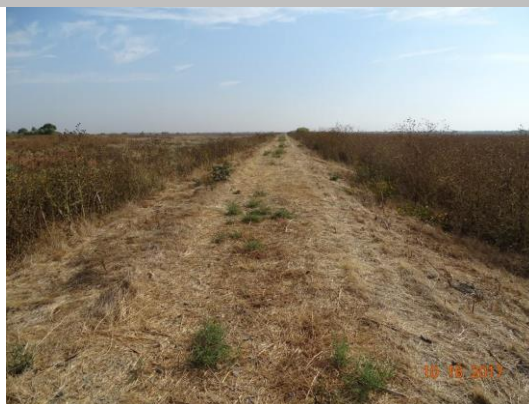
Photo 1 of 2 : SP\_2018\_NA0010\_141\_8\_20180307\_00003.jpg

LM Start	0.00	Rating **	M	Issue No.	8
LM End	1.76	Issue Type +	Ma	Location *	CR
Category	Earthen Levee			GPS Latitude/Longitude	
				Start	End
Item	Vegetation			37.296259 °	37.281615 °
				-120.880677 °	-120.867133 °
DWR ID	DWR_NA0010_25_s_2012_8				
Comment Code					
V2 : Remove the wild growth other than native grasses from the levee slopes.					
Inspector Comment					
Control weeds on levee crown.

Looking south at the levee crown.

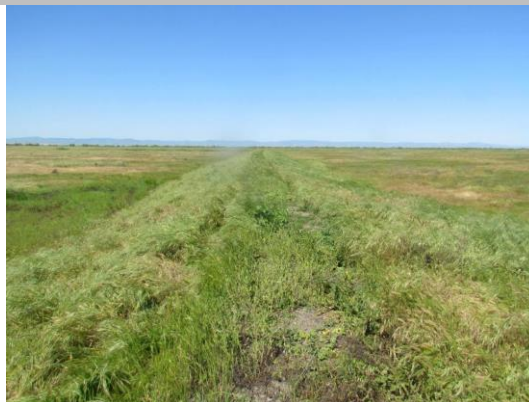
Photo 2 of 2 : SP\_2018\_NA0010\_141\_8\_20180307\_00004.jpg

LM Start	<b>0.00</b>	Rating **	M	Issue No.	<b>8 (cont)</b>
LM End	<b>1.76</b>	Issue Type +	Ma	Location *	CR

Looking at typical view of levee crown.

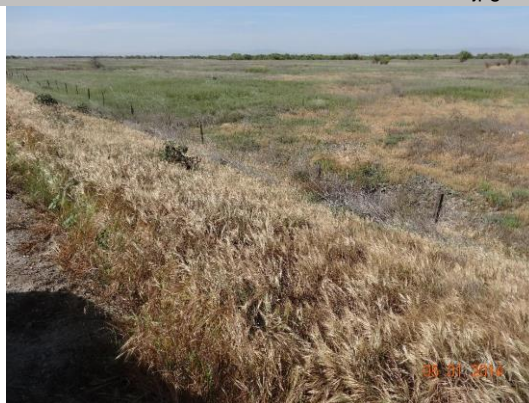
Photo 1 of 3 : UCIP\_SP\_2018\_39501\_67242.jpg

FS\_ID:39501  
DS\_ID:19965  
EP\_NO: N/A  
Repair Type: Non-Urgent  
Crossing Status: Found  
UCIP Comments: Dense vegetation limits the inspectors visibility to identify signs of pipe failure (leaks) along the slope. Recommend removing vegetation along pipe alignment to conduct proper inspection of structure. Sediment buildup in pipe visible from landward side--recommend clearing.  
FIELD\_STRUCT\_DESC: 24-inch corrugated metal gravity drainage pipe through the levee, 10 feet below the crown. Flap gate on the waterside (WS) end. [Additional Reference(s): DWR Levee Log, 2002. USACE San Joaquin O&M Manual 601.1, 1967, (HLM 0.02)].  
FS Date: 5/1/2014

View of waterward side--dense vegetation on waterward side.

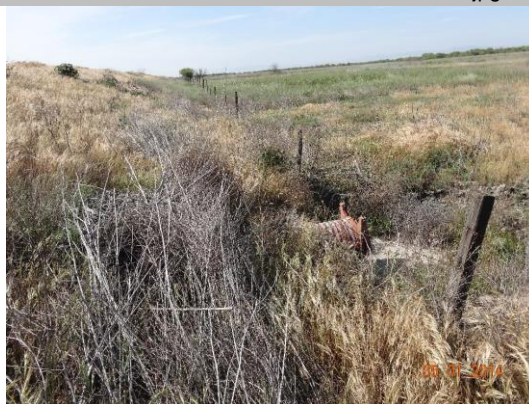
Photo 2 of 3 : UCIP\_SP\_2018\_39501\_67240.jpg

Pipe daylight visible on waterward toe.

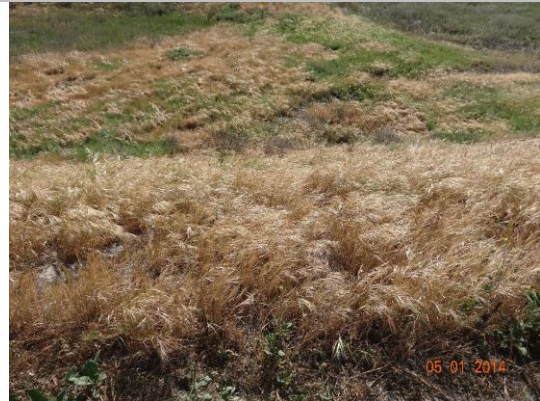
Photo 3 of 3 : UCIP\_SP\_2018\_39501\_67241.jpg

Comment Code						
Inspector Comment						
FS_ID:39501 DS_ID:19965 EP_NO: N/A Repair Type: Non-Urgent Crossing Status: Found UCIP Comments: Dense vegetation limits the inspectors visibility to identify signs of pipe failure (leaks) along the slope. Recommend removing vegetation along pipe alignment to conduct proper inspection of structure. Sediment buildup in pipe visible from landward side--recommend clearing. FIELD_STRUCT_DESC: 24-inch corrugated metal gravity drainage pipe through the levee, 10 feet below the crown. Flap gate on the waterside (WS) end. [Additional Reference(s): DWR Levee Log, 2002. USACE San Joaquin O&M Manual 601.1, 1967, (HLM 0.02)]. FS Date: 5/1/2014

View of landward side--dense vegetation on landward side.

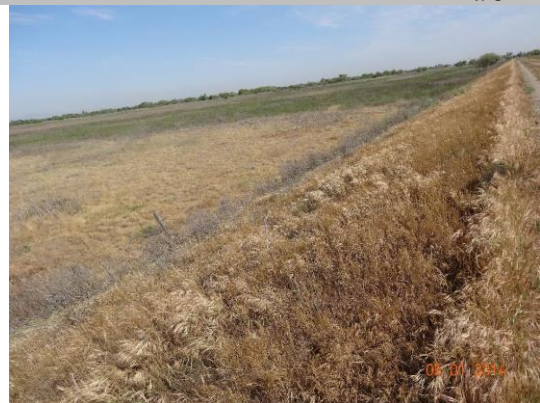
Photo 1 of 3 : UCIP\_SP\_2018\_36851\_67249.jpg

LM Start	0.36	Rating **	M	Issue No.	15
LM End	0.36	Issue Type +	Ma	Location *	
Category	Supplemental			GPS Latitude/Longitude	
				Start	End
Item	DWR UCIP LMA Responsibility			37.291173 °	37.291173 °
				-120.880731 °	-120.880731 °
DWR ID					
Comment Code					
Inspector Comment					
FS_ID:36851 DS_ID:19966 EP_NO: N/A Repair Type: Non-Urgent Crossing Status: Found UCIP Comments: Dense vegetation limits the inspectors visibility to identify signs of pipe failure (leaks) along the slope. Recommend removing vegetation along pipe alignment to conduct proper inspection of structure. FIELD_STRUCT_DESC: 24-inch corrugated metal gravity drainage pipe through the levee, 11.6 feet below the crown. Flap gate on the waterside (WS) end. [Additional Reference(s): DWR Levee Log, 2002. USACE San Joaquin O&M Manual 601.1, 1967, (HLM 0.35)]. FS Date: 5/1/2014

View of waterward side.

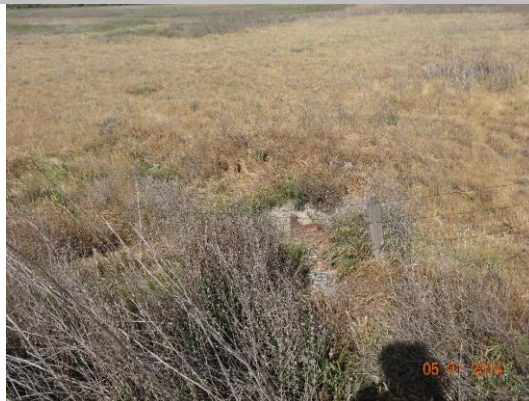
Photo 2 of 3 : UCIP\_SP\_2018\_36851\_67248.jpg

LM Start	0.36	Rating **	M	Issue No.	15 (cont)	
LM End	0.36	Issue Type +	Ma	Location *		
Category	Supplemental			GPS Latitude/Longitude		
				Start	End	
Item	DWR UCIP LMA Responsibility			37.291173 °	37.291173 °	
				-120.880731 °	-120.880731 °	
DWR ID						
Comment Code						
Inspector Comment						
FS_ID:36851 DS_ID:19966 EP_NO: N/A Repair Type: Non-Urgent Crossing Status: Found UCIP Comments: Dense vegetation limits the inspectors visibility to identify signs of pipe failure (leaks) along the slope. Recommend removing vegetation along pipe alignment to conduct proper inspection of structure. FIELD_STRUCT_DESC: 24-inch corrugated metal gravity drainage pipe through the levee, 11.6 feet below the crown. Flap gate on the waterside (WS) end. [Additional Reference(s): DWR Levee Log, 2002. USACE San Joaquin O&M Manual 601.1, 1967, (HLM 0.35)]. FS Date: 5/1/2014

Pipe outlet visible on waterward side.

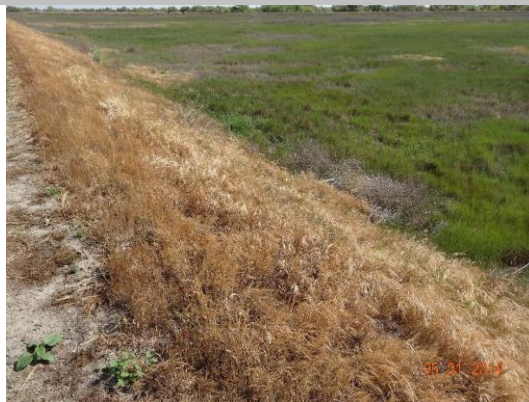
Photo 3 of 3 : UCIP\_SP\_2018\_36851\_67247.jpg

LM Start	<b>0.36</b>	Rating **	M	Issue No.	<b>15 (cont)</b>
LM End	<b>0.36</b>	Issue Type +	Ma	Location *

View of landward side.

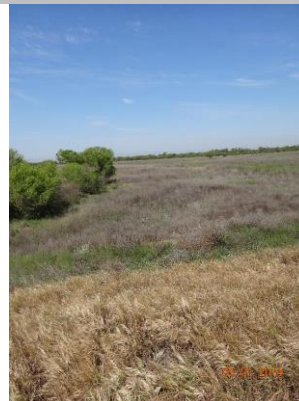
Photo 1 of 3 : UCIP\_SP\_2018\_36852\_67250.jpg

LM Start	0.59	Rating **	M	Issue No.	16
LM End	0.59	Issue Type +	Ma	Location *	
Category	Supplemental			GPS Latitude/Longitude	
				Start	End
Item	DWR UCIP LMA Responsibility			37.287744 °	37.287744 °
				-120.880645 °	-120.880645 °
DWR ID					
Comment Code					
Inspector Comment					
FS_ID:36852 DS_ID:19967 EP_NO: N/A Repair Type: Non-Urgent Crossing Status: Found UCIP Comments: Dense vegetation limits the inspectors visibility to identify signs of pipe failure (leaks) along the slope. Recommend removing vegetation along pipe alignment to conduct proper inspection of structure. FIELD_STRUCT_DESC: 24-inch corrugated metal gravity drainage pipe through the levee, 14.7 feet below the crown. Flap gate on the waterside (WS) end. [Additional Reference(s): DWR Levee Log, 2002. USACE San Joaquin O&M Manual 601.1, 1967, (HLM 0.59)]. FS Date: 5/1/2014

Overview of waterward side--Salt Slough.

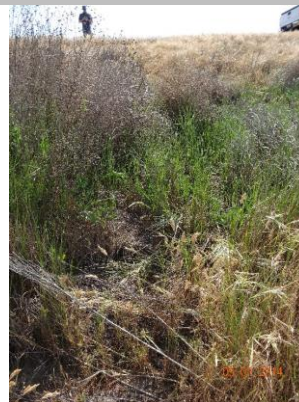
Photo 2 of 3 : UCIP\_SP\_2018\_36852\_67251.jpg

LM Start	<b>0.59</b>	Rating **	M	Issue No.	<b>16 (cont)</b>
LM End	<b>0.59</b>	Issue Type +	Ma	Location *

View of waterward slope covered by dense vegetation.

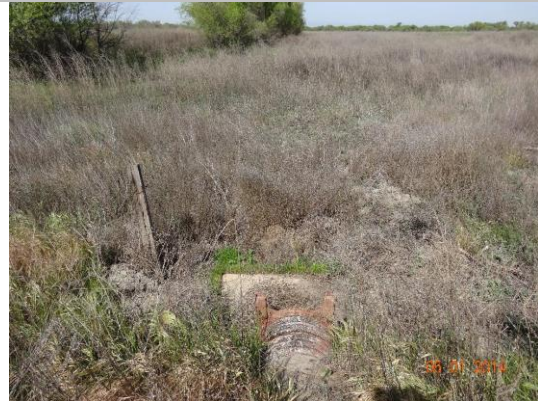
Photo 3 of 3 : UCIP\_SP\_2018\_36852\_67252.jpg

LM Start	0.59	Rating **	M	Issue No.	16 (cont)	
LM End	0.59	Issue Type +	Ma	Location *		
Category	Supplemental			GPS Latitude/Longitude		
				Start	End	
Item	DWR UCIP LMA Responsibility			37.287744 °	37.287744 °	
				-120.880645 °	-120.880645 °	
DWR ID						
Comment Code						
Inspector Comment						
FS_ID:36852 DS_ID:19967 EP_NO: N/A Repair Type: Non-Urgent Crossing Status: Found UCIP Comments: Dense vegetation limits the inspectors visibility to identify signs of pipe failure (leaks) along the slope. Recommend removing vegetation along pipe alignment to conduct proper inspection of structure. FIELD_STRUCT_DESC: 24-inch corrugated metal gravity drainage pipe through the levee, 14.7 feet below the crown. Flap gate on the waterside (WS) end. [Additional Reference(s): DWR Levee Log, 2002. USACE San Joaquin O&M Manual 601.1, 1967, (HLM 0.59)]. FS Date: 5/1/2014

Pipe and flap gate visible on waterward side.

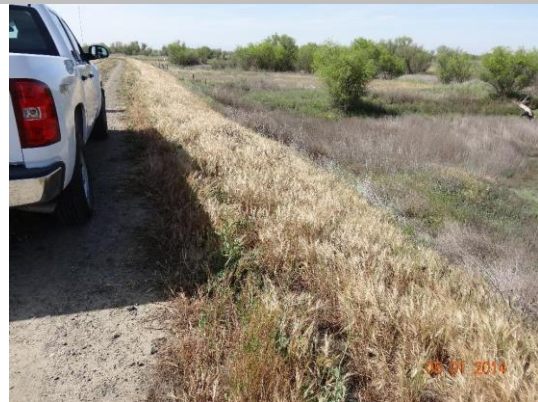
Photo 1 of 3 : UCIP\_SP\_2018\_36853\_67256.jpg

LM Start	0.97	Rating **	M	Issue No.	17	
LM End	0.97	Issue Type +	Ma	Location *		
Category	Supplemental			GPS Latitude/Longitude		
				Start		End
Item	DWR UCIP LMA Responsibility			37.282252 °		37.282252 °
				-120.880738 °		-120.880738 °
DWR ID						
Comment Code						
Inspector Comment						
FS_ID:36853 DS_ID:19968 EP_NO: N/A Repair Type: Non-Urgent Crossing Status: Found UCIP Comments: Dense vegetation limits the inspectors visibility to identify signs of pipe failure (leaks) along the slope. Recommend removing vegetation along pipe alignment to conduct proper inspection of structure. FIELD_STRUCT_DESC: 24-inch corrugated metal gravity drainage pipe through the levee, 11.4 feet below the crown. Flap gate on the waterside (WS) end. [Additional Reference(s): DWR Levee Log, 2002. USACE San Joaquin O&M Manual 601.1, 1967, (HLM 0.97)]. FS Date: 5/1/2014

View of waterward side.

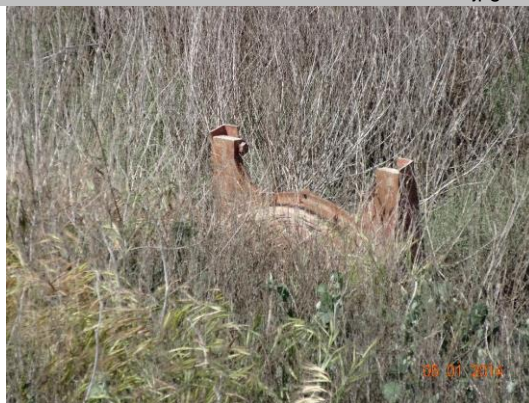
Photo 2 of 3 : UCIP\_SP\_2018\_36853\_67255.jpg

LM Start	0.97	Rating **	M	Issue No.	17 (cont)	
LM End	0.97	Issue Type +	Ma	Location *		
Category	Supplemental			GPS Latitude/Longitude		
				Start	End	
Item	DWR UCIP LMA Responsibility			37.282252 °	37.282252 °	
				-120.880738 °	-120.880738 °	
DWR ID						
Comment Code						
Inspector Comment						
FS_ID:36853 DS_ID:19968 EP_NO: N/A Repair Type: Non-Urgent Crossing Status: Found UCIP Comments: Dense vegetation limits the inspectors visibility to identify signs of pipe failure (leaks) along the slope. Recommend removing vegetation along pipe alignment to conduct proper inspection of structure. FIELD_STRUCT_DESC: 24-inch corrugated metal gravity drainage pipe through the levee, 11.4 feet below the crown. Flap gate on the waterside (WS) end. [Additional Reference(s): DWR Levee Log, 2002. USACE San Joaquin O&M Manual 601.1, 1967, (HLM 0.97)]. FS Date: 5/1/2014

Pipe and evidence of flap gate visible on waterward side.

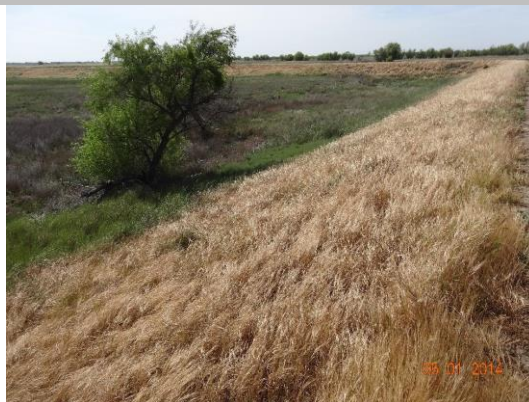
Photo 3 of 3 : UCIP\_SP\_2018\_36853\_67254.jpg

View of landward side.

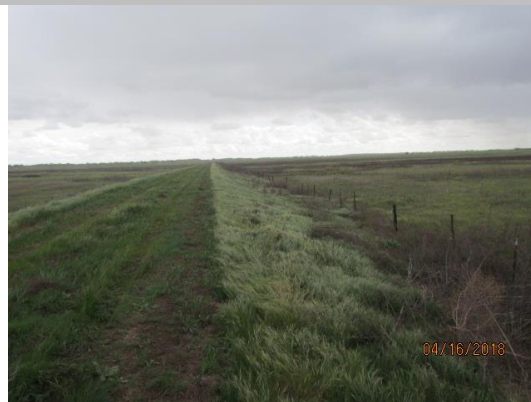
Photo 1 of 1 : SP\_2018\_NA0010\_141\_11\_20180419\_00025.jpg

LM Start	1.00	Rating **	M	Issue No.	11
LM End	2.49	Issue Type +	Ma	Location *	WS
Category	Earthen Levee			GPS Latitude/Longitude	
				Start	End
Item	Vegetation			37.281791 °	37.271073 °
				-120.880747 °	-120.866562 °
DWR ID	DWR_NA0010_25_s_2018_11				
Comment Code					
V1 : Control annual grass and weeds on the levee slopes and easements.					
Inspector Comment

Looking northeast at typical view of waterward slope. (Spring 2018)

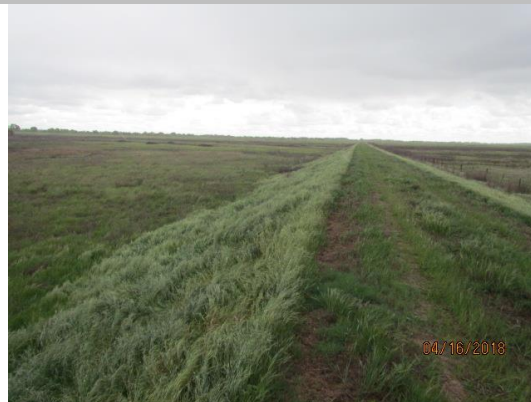
Photo 1 of 1 : SP\_2018\_NA0010\_141\_10\_20180419\_00026.jpg

LM Start	1.00	Rating **	M	Issue No.	10
LM End	2.49	Issue Type +	Ma	Location *	LS
Category	Earthen Levee			GPS Latitude/Longitude	
				Start	End
Item	Vegetation			37.281791 °	37.271073 °
				-120.880746 °	-120.866562 °
DWR ID	DWR_NA0010_25_s_2018_10				
Comment Code					
V1 : Control annual grass and weeds on the levee slopes and easements.					
Inspector Comment

Looking north at typical view of landward slope. (Spring 2018)

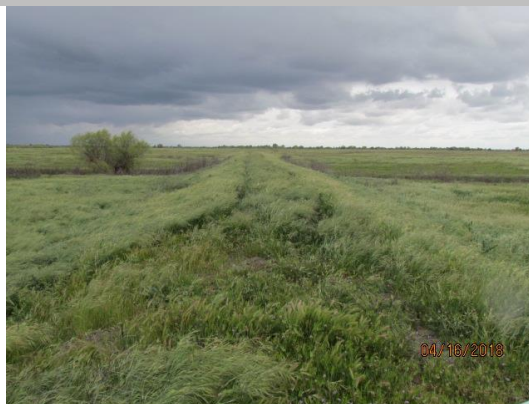
Photo 1 of 1 : SP\_2018\_NA0010\_141\_12\_20180419\_00027.jpg

LM Start	1.75	Rating **	U	Issue No.	12
LM End	2.49	Issue Type +	Ma	Location *	CR
Category	Earthen Levee			GPS Latitude/Longitude	
				Start	End
Item	Vegetation			37.281677 °	37.271073 °
				-120.867254 °	-120.866562 °
DWR ID	DWR_NA0010_25_s_2018_12				
Comment Code					
V2 : Remove the wild growth other than native grasses from the levee slopes.					
Inspector Comment

Looking east at typical view of levee crown. (Spring 2018)

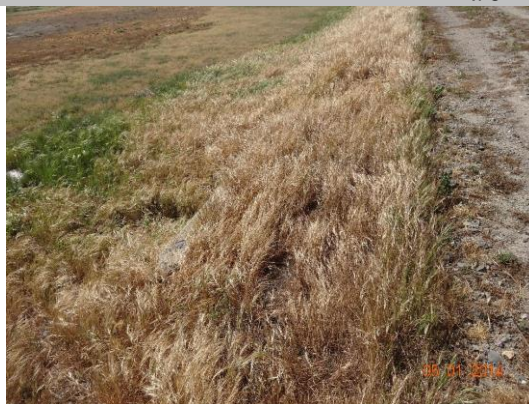
Photo 1 of 3 : UCIP\_SP\_2018\_36854\_67259.jpg

LM Start	2.05	Rating **	M	Issue No.	18
LM End	2.05	Issue Type +	Ma	Location *	
Category	Supplemental			GPS Latitude/Longitude	
				Start	End
Item	DWR UCIP LMA Responsibility			37.277390 °	37.277390 °
				-120.867184 °	-120.867184 °
DWR ID					
Comment Code					
Inspector Comment					
FS_ID:36854 DS_ID:19969 EP_NO: N/A Repair Type: Non-Urgent Crossing Status: Found UCIP Comments: Dense vegetation limits the inspectors visibility to identify signs of pipe failure (leaks) along the slope. Recommend removing vegetation along pipe alignment to conduct proper inspection of structure. FIELD_STRUCT_DESC: 24-inch corrugated metal gravity drainage pipe through the levee, 4 feet below the crown. Flap gate on the waterside (WS) end. [Additional Reference(s): DWR Levee Log, 2002. USACE San Joaquin O&M Manual 601.1, 1967, (HLM 2.05)]. FS Date: 5/1/2014

View of landward side.

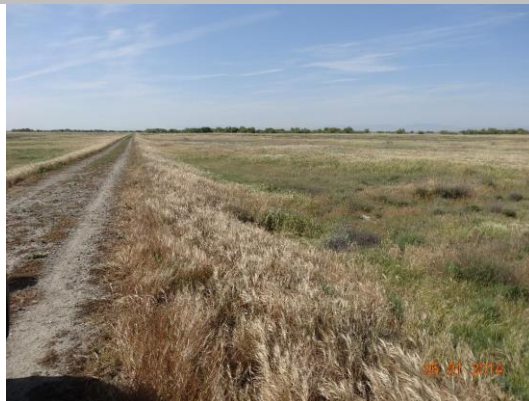
Photo 2 of 3 : UCIP\_SP\_2018\_36854\_67260.jpg

LM Start	2.05	Rating **	M	Issue No.	18 (cont)	
LM End	2.05	Issue Type +	Ma	Location *		
Category	Supplemental			GPS Latitude/Longitude		
				Start		End
Item	DWR UCIP LMA Responsibility			37.277390 °		37.277390 °
				-120.867184 °		-120.867184 °
DWR ID						
Comment Code						
Inspector Comment						
FS_ID:36854 DS_ID:19969 EP_NO: N/A Repair Type: Non-Urgent Crossing Status: Found UCIP Comments: Dense vegetation limits the inspectors visibility to identify signs of pipe failure (leaks) along the slope. Recommend removing vegetation along pipe alignment to conduct proper inspection of structure. FIELD_STRUCT_DESC: 24-inch corrugated metal gravity drainage pipe through the levee, 4 feet below the crown. Flap gate on the waterside (WS) end. [Additional Reference(s): DWR Levee Log, 2002. USACE San Joaquin O&M Manual 601.1, 1967, (HLM 2.05)]. FS Date: 5/1/2014

View of waterward side.
