**Flood Control Project Maintenance  
Levee Inspections**

## Maintenance Issue Types Only, Levee Inspection Report By Mile - Spring 2019

### Lower San Joaquin Levee District

Waterway	Bank	Unit Miles	Inspection Start/End	Inspector
Unit No. 01 San Joaquin River	Right	22.52	03/26/2019 03/26/2019	Corey Fujitani

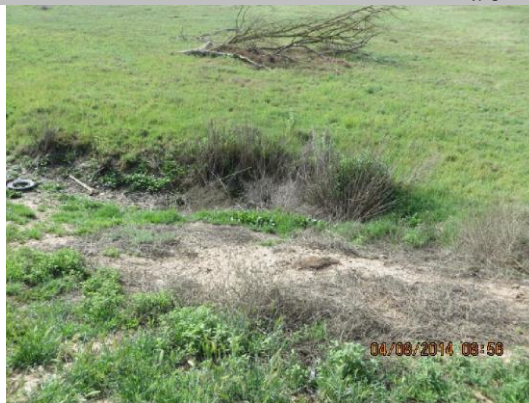
Photo 3 of 3 : UCIP\_SP\_2019\_39091\_60602.jpg

Comment Code						
Inspector Comment						
FS_ID:39091 DS_ID:19650 EP_NO: N/A Repair Type: Non-Urgent Crossing Status: Found UCIP Comments: 04/08/2014 Dense vegetation limits the inspector's visibility to identify signs of pipe failure (leaks) along the waterward slope and landward toe. Recommend removing vegetation along pipe alignment and landward toe to conduct proper inspection of structure and appurtenances. (DWR UCIP - W. Wylie) FIELD_STRUCT_DESC: 24-inch corrugated metal gravity drainage pipe through the levee, 10.5 feet below the crown. Flap gate on the waterside (WS) end. Brass cap No. 108 bench mark (BM) on the headwall on the landside (LS), elevation 65.1 feet, USGS Datum. [Additional Reference(s): DWR Levee Log, 2002. USACE San Joaquin O&M Manual 601.1, 1967, (HLM 0.02)]. FS Date: 4/8/2014 7:34:00 AM

Headwall on LS toe.

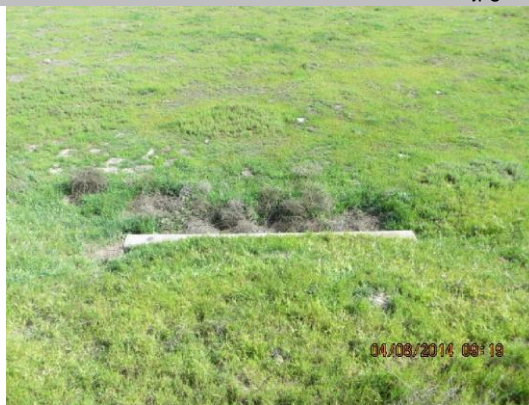
Photo 2 of 3 : UCIP\_SP\_2019\_33524\_60626.jpg

Pipe and headwall visible on LS toe.

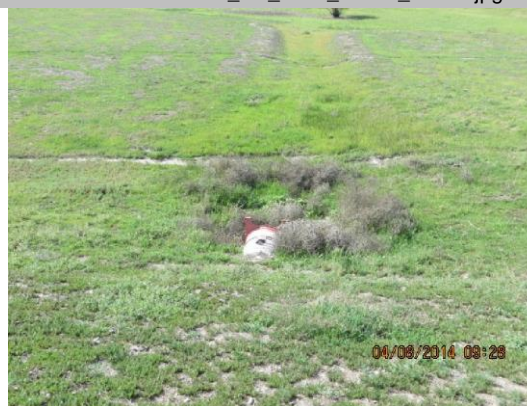
Photo 1 of 3 : UCIP\_SP\_2019\_33543\_60642.jpg

LM Start	1.15	Rating **	A/W	Issue No.	1190
LM End	1.15	Issue Type +	Ma	Location *	
Category	Supplemental			GPS Latitude/Longitude	
				Start	End
Item	DWR UCIP LMA Responsibility			37.338005 °	37.338005 °
				-120.953921 °	-120.953921 °
DWR ID	19586				
Comment Code					
Inspector Comment					
FS_ID:33543					
DS_ID:19586					
EP_NO: N/A					
Repair Type: No Action Needed					
Crossing Status: Found					
UCIP Comments:					
FIELD_STRUCT_DESC: 24-inch corrugated metal gravity drainage pipe through the levee, 7.5 feet below the crown. Flap gate on the waterside (WS) end. Brass cap No. 108 bench mark (BM) on the headwall on the landside (LS). [Additional Reference(s): DWR Levee Log, 2002. USACE San Joaquin O&M Manual 601.1, 1967, (HLM 1.17)].					
FS Date: 4/8/2014

Pipe, headwall, and flapgate visible on WS toe.

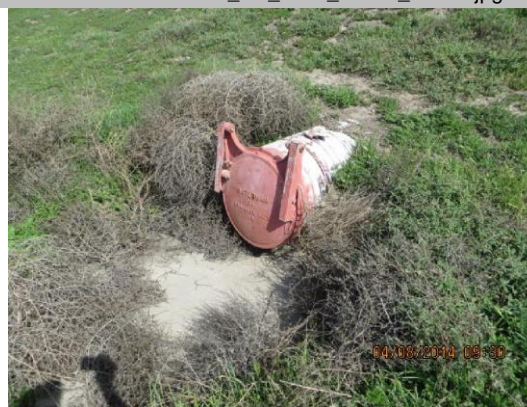
Photo 2 of 3 : UCIP\_SP\_2019\_33543\_60643.jpg

Pipe, headwall, and flapgate visible on WS toe.

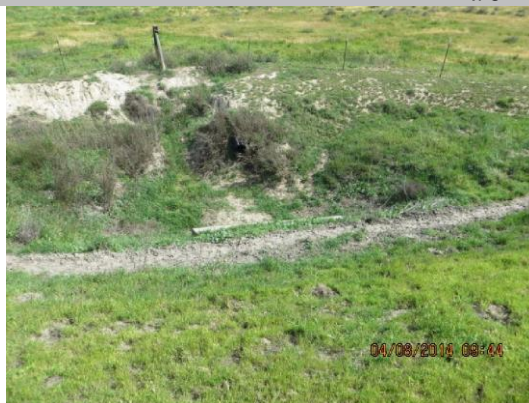
Photo 3 of 3 : UCIP\_SP\_2019\_33563\_60662.jpg

Pipe and headwall visible on LS toe.

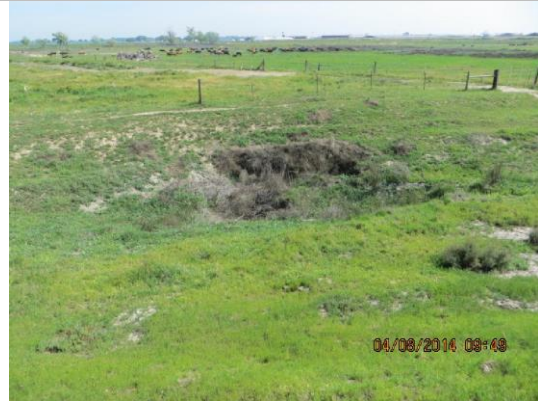
Photo 3 of 3 : UCIP\_SP\_2019\_33564\_60665.jpg

LM Start	1.81	Rating **	A/W	Issue No.	1194 (cont)	
LM End	1.81	Issue Type +	Ma	Location *		
Category	Supplemental			GPS Latitude/Longitude		
				Start		End
Item	DWR UCIP LMA Responsibility			37.335612 °		37.335612 °
				-120.942532 °		-120.942532 °
DWR ID	19590					
Comment Code						
Inspector Comment						
FS_ID:33564						
DS_ID:19590						
EP_NO: N/A						
Repair Type: No Action Needed						
Crossing Status: Found						
UCIP Comments:						
FIELD_STRUCT_DESC: 36-inch corrugated metal gravity drainage pipe						
through the levee, 14.2 feet below the crown. Flap gate on the						
waterside (WS) end. Brass cap No. 100 bench mark (BM) on the						
headwall on the landside (LS). [Additional Reference(s): DWR Levee						
Log, 2002. USACE San Joaquin O&M Manual 601.1, 1967, (HLM 1.83)].						
FS Date: 4/8/2014

Pipe and concrete headwall visible at LS toe.

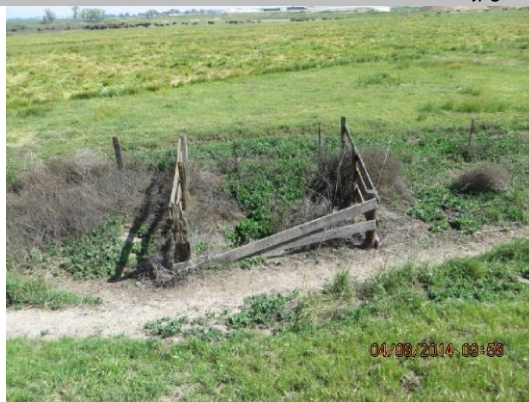
Photo 3 of 3 : UCIP\_SP\_2019\_39100\_60671.jpg

Comment Code						
Inspector Comment						
FS_ID:39100						
DS_ID:19591						
EP_NO: N/A						
Repair Type: Non-Urgent						
Crossing Status: Found						
UCIP Comments: 04/08/2014 Need to contact owner to determine crossing status. Inlet drop box silted in and needs to be cleaned out. (DWR UCIP - W. Wylie)						
FIELD_STRUCT_DESC: 24-inch corrugated metal gravity drainage pipe through the levee, 9.7 feet below the crown. Flap gate on the waterside (WS) end. Brass cap No. 100 bench mark (BM) on the headwall on the landside (LS). Wooden barrier around drop inlet on the LS toe. [Additional Reference(s): DWR Levee Log, 2002. USACE San Joaquin O&M Manual 601.1, 1967, (HLM 1.98)].						
FS Date: 4/8/2014

Wooded barrier around drop-inlet on LS toe.

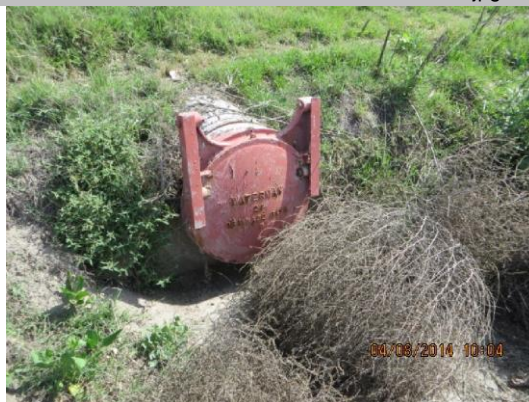
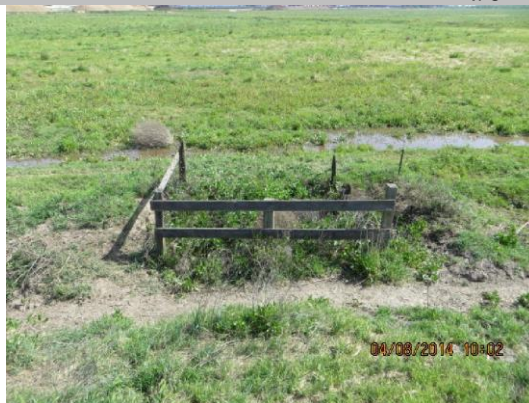
LM Start	2.06	Rating **	M	Issue No.	1196	
LM End	2.06	Issue Type +	Ma	Location *		
Category	Supplemental			GPS Latitude/Longitude		
				Start		End
Item	DWR UCIP LMA Responsibility			37.333653 °	37.333653 °	
				-120.938770 °	-120.938770 °	
DWR ID	19570					
Comment Code						
Inspector Comment						
FS_ID:39123 DS_ID:19570 EP_NO: N/A Repair Type: Non-Urgent Crossing Status: Found UCIP Comments: 04/08/2014 Unable to find inlet on landward toe. Recommend clearing vegetation on landward side to properly inspect inlet. (DWR UCIP - W. Wylie) FIELD_STRUCT_DESC: 24-inch corrugated metal gravity drainage pipe through the levee, 9.8 feet below the crown. Flap gate on the waterside (WS) end. Brass cap No. 100 bench mark (BM) on the headwall on the landside (LS). [Additional Reference(s): DWR Levee Log, 2002. USACE San Joaquin O&M Manual 601.1, 1967, (HLM 2.08)]. FS Date: 4/8/2014

Pipe and flapgate visible on WS toe.

Wooded barrier around drop-inlet on LS toe.

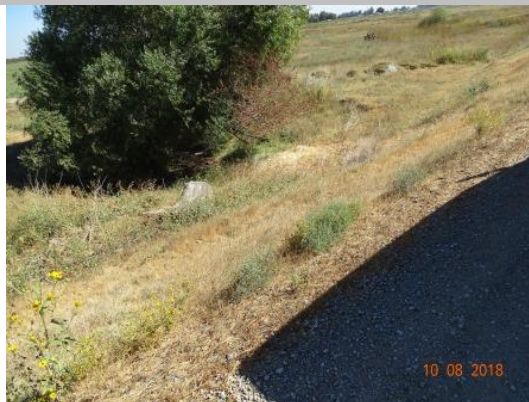
LM Start	2.20	Rating **	N	Issue No.	110
LM End	2.20	Issue Type +	Ma	Location *	LS
Category	Earthen Levee			GPS Latitude/Longitude	
				Start	End
Item	Trim / Thin Trees			37.331820 °	37.331820 °
				-120.937605 °	-120.937605 °
DWR ID	DWR_NA0010_01_f_2018_110				
Comment Code					
T5 : Tree stumps.					
Inspector Comment					
Tree stump on landside slope should be removed

View of tree stump on landside slope. (Fall 2018)

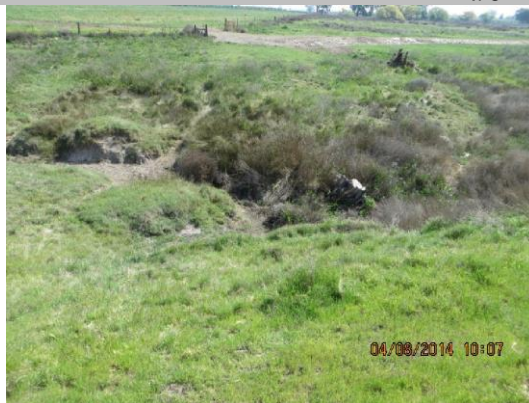
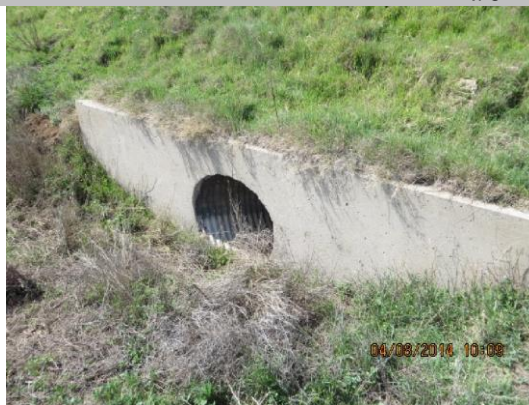
LM Start	2.22	Rating **	A/W	Issue No.	1197
LM End	2.22	Issue Type +	Ma	Location *	
Category	Supplemental			GPS Latitude/Longitude	
				Start	End
Item	DWR UCIP LMA Responsibility			37.331611 °	37.331611 °
				-120.937455 °	-120.937455 °
DWR ID	19571				
Comment Code					
Inspector Comment					
FS_ID:39125					
DS_ID:19571					
EP_NO: N/A					
Repair Type: No Action Needed					
Crossing Status: Found					
UCIP Comments:					
FIELD_STRUCT_DESC: 36-inch corrugated metal gravity drainage pipe through the levee, 12.6 feet below the crown. Flap gate on the waterside (WS) end. Brass cap No. 100 bench mark (BM) on the headwall on the landside (LS). Wooden barrier around drop inlet on the LS toe. [Additional Reference(s): DWR Levee Log, 2002. USACE San Joaquin O&M Manual 601.1, 1967, (HLM 2.25)].					
FS Date: 4/8/2014

Pipe and flapgate on WS toe.

Pipe and headwall on LS toe.

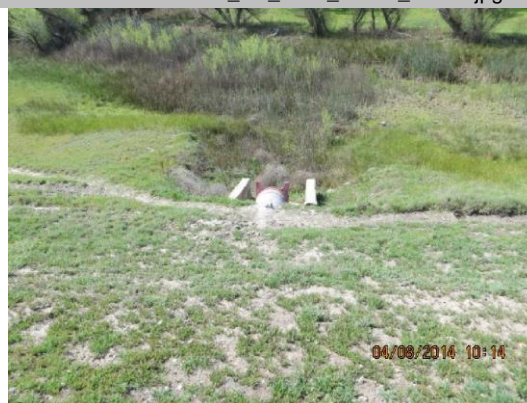
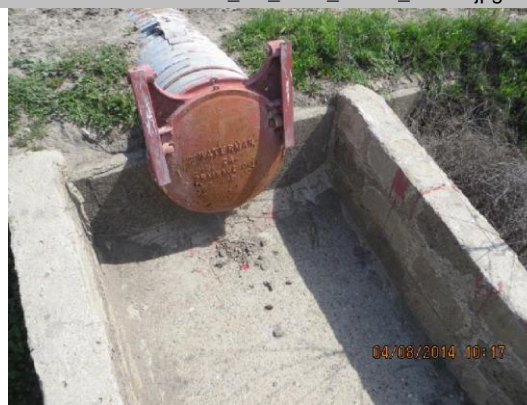
LM Start	2.50	Rating **	A/W	Issue No.	1198
LM End	2.50	Issue Type +	Ma	Location *	
Category	Supplemental			GPS Latitude/Longitude	
				Start	End
Item	DWR UCIP LMA Responsibility			37.328619 °	37.328619 °
				-120.934369 °	-120.934369 °
DWR ID	19572				
Comment Code					
Inspector Comment					
FS_ID:33568					
DS_ID:19572					
EP_NO: N/A					
Repair Type: No Action Needed					
Crossing Status: Found					
UCIP Comments:					
FIELD_STRUCT_DESC: 24-inch corrugated metal gravity drainage pipe					
through the levee, 8 feet below the crown. Flap gate on the waterside					
(WS) end. Brass cap No. 100 bench mark (BM) on the headwall on the					
landside (LS). [Additional Reference(s): DWR Levee Log, 2002. USACE					
San Joaquin O&M Manual 601.1, 1967, (HLM 2.52)].					
FS Date: 4/8/2014

Pipe, headwall, and flapgate on WS toe.

Pipe and headwall on LS toe.

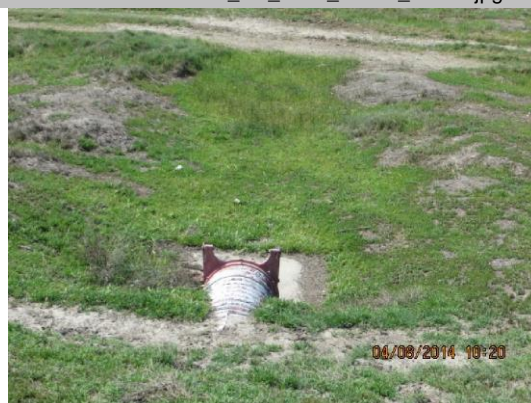
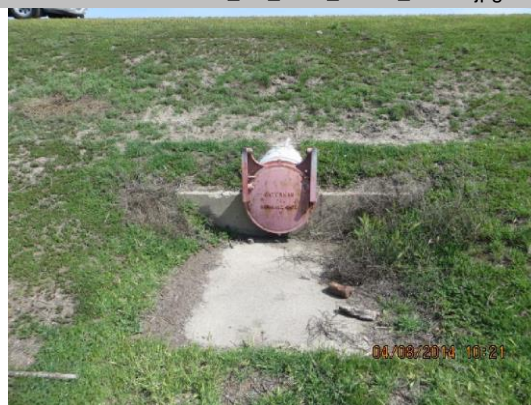
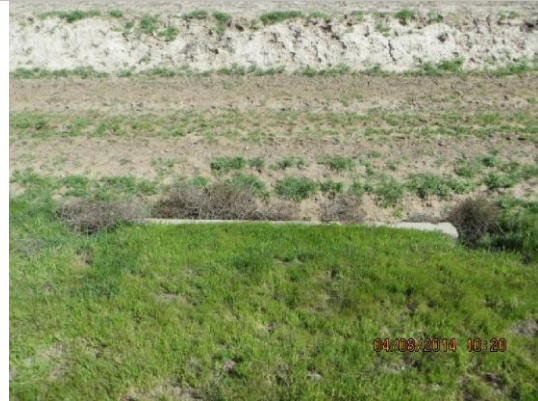
LM Start	2.67	Rating **	M	Issue No.	1199	
LM End	2.67	Issue Type +	Ma	Location *		
Category	Supplemental			GPS Latitude/Longitude		
				Start		End
Item	DWR UCIP LMA Responsibility			37.327362 °		37.327362 °
				-120.931591 °		-120.931591 °
DWR ID	19573					
Comment Code						
Inspector Comment						
FS_ID:39127 DS_ID:19573 EP_NO: N/A Repair Type: Non-Urgent Crossing Status: Found UCIP Comments: 04/08/2014 Sedimentation in pipe at landward toe. (DWR UCIP - W. Wylie) FIELD_STRUCT_DESC: 24-inch corrugated metal gravity drainage pipe through the levee, 7.3 feet below the crown. Flap gate on the waterside (WS) end. Brass cap No. 100 bench mark (BM) on the headwall on the landside (LS). [Additional Reference(s): DWR Levee Log, 2002. USACE San Joaquin O&M Manual 601.1, 1967, (HLM 2.70)]. FS Date: 4/8/2014

Pipe, flapgate, and headwall on WS toe.

Pipe and headwall on LS toe.

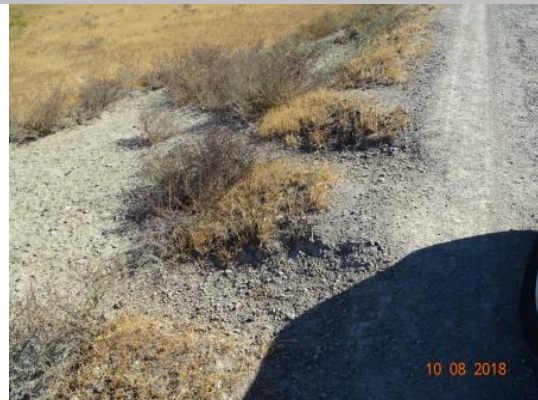
Photo 1 of 1 : SP\_2019\_NA0010\_118\_114\_20190307\_00032.jpg

LM Start	2.99	Rating **	M	Issue No.	114
LM End	2.99	Issue Type +	Ma	Location *	LS
Category	Earthen Levee			GPS Latitude/Longitude	
				Start	End
Item	Slope Stability			37.323328 °	37.323328 °
				-120.929521 °	-120.929521 °
DWR ID	DWR_NA0010_01_f_2018_114				
Comment Code					
S2 : Repair the levee slope damaged by foot traffic and prevent access where possible.					
Inspector Comment					
Slope damage caused by livestock.

View of slope damage caused by livestock. (Fall 2018)

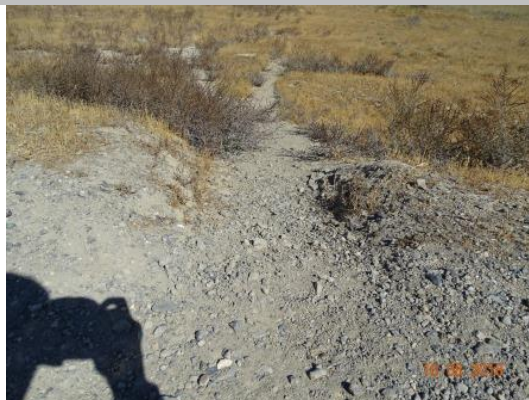
LM Start	3.10	Rating **	M	Issue No.	115
LM End	3.10	Issue Type +	Ma	Location *	LS
Category	Earthen Levee			GPS Latitude/Longitude	
				Start	End
Item	Slope Stability			37.321903 °	37.321903 °
				-120.928748 °	-120.928748 °
DWR ID	DWR_NA0010_01_f_2018_115				
Comment Code					
S2 : Repair the levee slope damaged by foot traffic and prevent access where possible.					
Inspector Comment					
Damage caused by foot traffic.

View of erosion path looking downstream. (Fall 2018)

View of erosion path looking down landside slope. (Fall 2018)

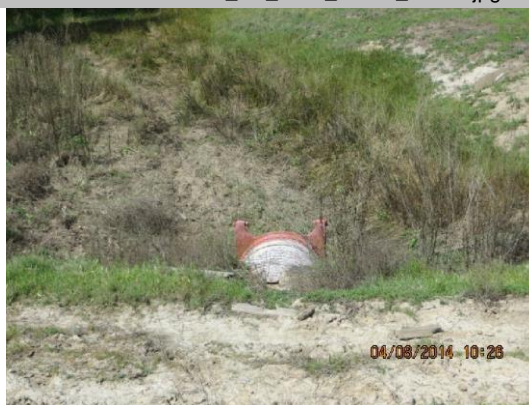
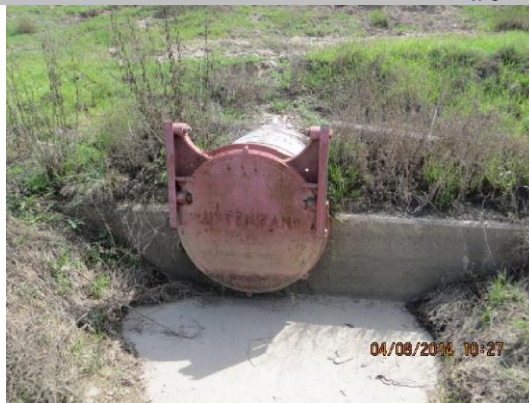
LM Start	3.13	Rating **	M	Issue No.	1200
LM End	3.13	Issue Type +	Ma	Location *	
Category	Supplemental			GPS Latitude/Longitude	
				Start	End
Item	DWR UCIP LMA Responsibility			37.321444 °	37.321444 °
				-120.928764 °	-120.928764 °
DWR ID	19574				
Comment Code					
Inspector Comment					
FS_ID:39128 DS_ID:19574 EP_NO: N/A Repair Type: Non-Urgent Crossing Status: Found UCIP Comments: 04/08/2014 Some minor erosion around headwall on LS toe. (DWR UCIP - W. Wylie) FIELD_STRUCT_DESC: 36-inch corrugated metal gravity drainage pipe through the levee, 8 feet below the crown. Flap gate on the waterside (WS) end. Brass cap No. 100 bench mark (BM) on the headwall on the landside (LS). [Additional Reference(s): DWR Levee Log, 2002. USACE San Joaquin O&M Manual 601.1, 1967, (HLM 3.16)]. FS Date: 4/8/2014

Pipe, Flapgate, and headwall on WS toe.

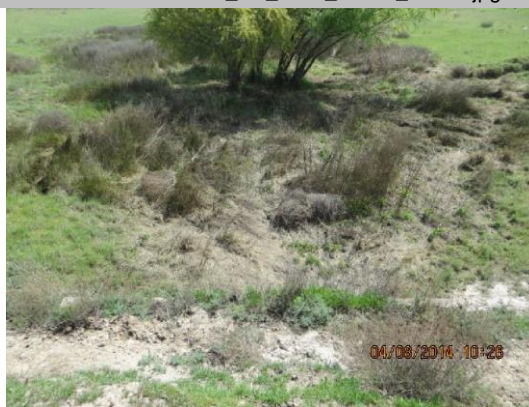
Photo 3 of 3 : UCIP\_SP\_2019\_39128\_60701.jpg

LM Start	3.13	Rating **	M	Issue No.	1200 (cont)	
LM End	3.13	Issue Type +	Ma	Location *		
Category	Supplemental			GPS Latitude/Longitude		
				Start		End
Item	DWR UCIP LMA Responsibility			37.321444 °		37.321444 °
				-120.928764 °		-120.928764 °
DWR ID	19574					
Comment Code						
Inspector Comment						
FS_ID:39128 DS_ID:19574 EP_NO: N/A Repair Type: Non-Urgent Crossing Status: Found UCIP Comments: 04/08/2014 Some minor erosion around headwall on LS toe. (DWR UCIP - W. Wylie) FIELD_STRUCT_DESC: 36-inch corrugated metal gravity drainage pipe through the levee, 8 feet below the crown. Flap gate on the waterside (WS) end. Brass cap No. 100 bench mark (BM) on the headwall on the landside (LS). [Additional Reference(s): DWR Levee Log, 2002. USACE San Joaquin O&M Manual 601.1, 1967, (HLM 3.16)]. FS Date: 4/8/2014

Pipe and headwall on LS toe.

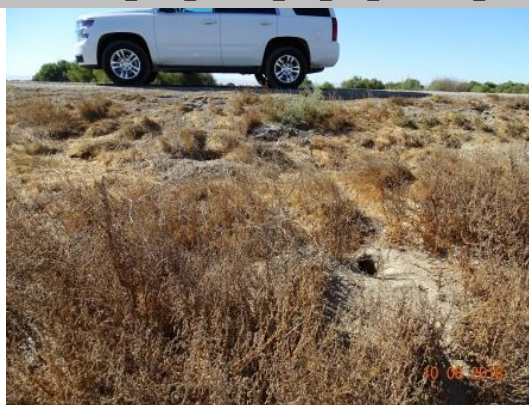
Photo 1 of 2 : SP\_2019\_NA0010\_118\_116\_20190307\_00035.jpg

LM Start	3.18	Rating **	M	Issue No.	116
LM End	3.18	Issue Type +	Ma	Location *	LS
Category	Earthen Levee			GPS Latitude/Longitude	
				Start	End
Item	Animal Control			37.320725 °	37.320725 °
				-120.928837 °	-120.928837 °
DWR ID	DWR_NA0010_01_f_2018_116				
Comment Code					
A3 : No rodents visible, but rodent burrows visible; need to backfill and compact or grout burrows.					
Inspector Comment					
Several rodent holes noted in this section.

View of landside slope with rodent holes. (Fall 2018)

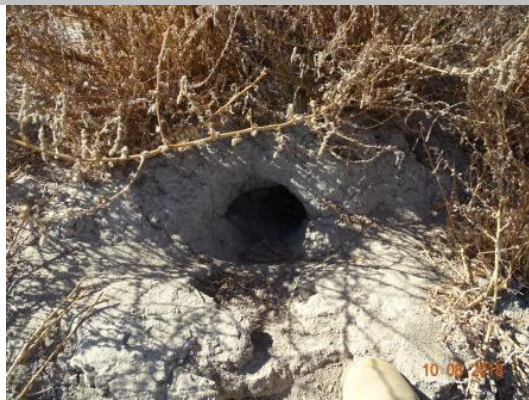
Photo 2 of 2 : SP\_2019\_NA0010\_118\_116\_20190307\_00036.jpg

Representative view of rodent holes in this section. (Fall 2018)

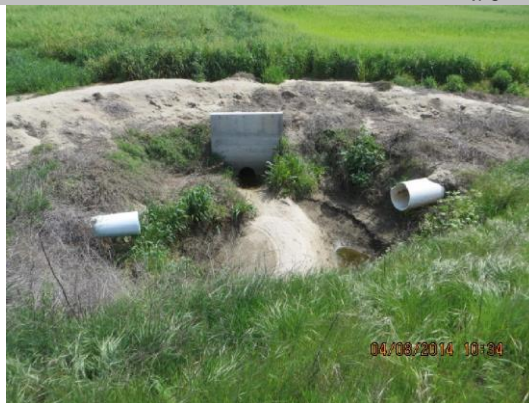
Photo 2 of 3 : UCIP\_SP\_2019\_53188\_60706.jpg

Comment Code						
Inspector Comment						
FS_ID:53188 DS_ID:19575 EP_NO: N/A Repair Type: Urgent Crossing Status: Found UCIP Comments: 11/01/2018 Pipe continues to rust through, causing the pipe to collapse on the LS. Sediment buildup visible from the LS inlet. Loss of soil just above the LS concrete headwall and along the LS slope. Crossing remains Urgent due to the levee slope issues and pipe failure through the levee. (O. Magana - DWR UCIP)07/19/2016 Same as previous inspection. Erosion present on LS slope. (DWR UCIP - O. Magana)04/08/2014 Pipe rusted through at Springline on LS toe. Flapgate blocked by sediment on WS toe. Heavy sediment on both ends of pipe. Need to contact owner to address issues. (DWR UCIP - W. Wylie) FIELD_STRUCT_DESC: 36-inch corrugated metal gravity drainage pipe through the levee, 9.7 feet below the crown. Flap gate on the waterside (WS) end. Brass cap No. 100 bench mark (BM) on the headwall on the landside (LS). [Additional Reference(s): DWR Levee Log, 2002. USACE San Joaquin O&M Manual 601.1, 1967, (HLM 3.50)]. FS Date: 11/1/2018 12:49:00 PM

Pipe and headwall on LS toe.

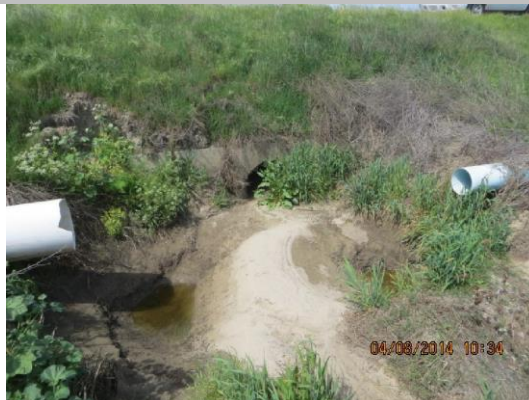
Photo 3 of 3 : UCIP\_SP\_2019\_53188\_60705.jpg

Pipe and headwall on LS toe.

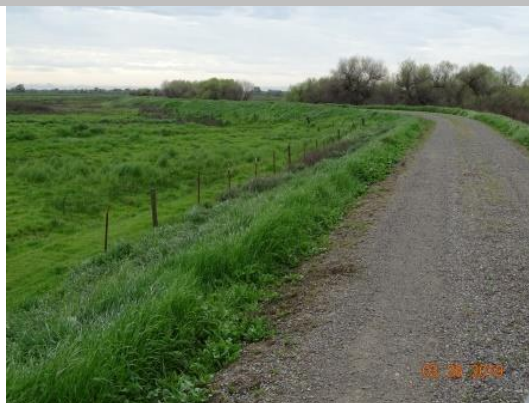
Photo 1 of 1 : SP\_2019\_NA0010\_118\_100\_20190402\_00286.jpg

LM Start	4.09	Rating **	M	Issue No.	100
LM End	7.81	Issue Type +	Ma	Location *	LS
Category	Earthen Levee			GPS Latitude/Longitude	
				Start	End
Item	Vegetation			37.309601 °	37.298553 °
				-120.924897 °	-120.871703 °
DWR ID	DWR_NA0010_01_s_2019_100				
Comment Code					
V1 : Control annual grass and weeds on the levee slopes and easements.					
Inspector Comment

View of vegetation on landside slope looking upstream. (Spring 2019)

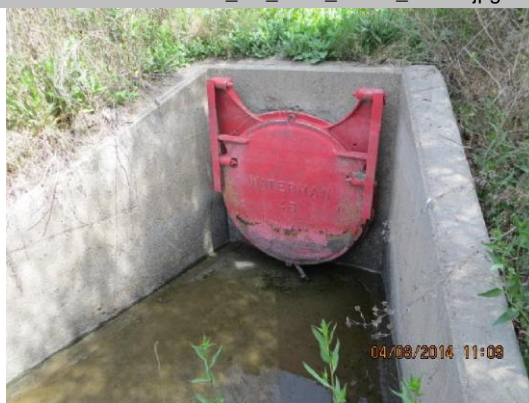
Photo 1 of 3 : UCIP\_SP\_2019\_39134\_60730.jpg

Comment Code						
Inspector Comment						
FS_ID:39134 DS_ID:19607 EP_NO: N/A Repair Type: Non-Urgent Crossing Status: Found UCIP Comments: 04/08/2014 Pipe appears sleeved with a 12-inch steel pipe with a slide gate at the LS toe. No identified authorization for changes to this crossing. Need to contact owner to obtain additional information about the modifications to crossing. (DWR UCIP - W. Wylie) FIELD_STRUCT_DESC: 48-inch corrugated metal gravity drainage pipe through the levee, 14 feet below the crown. Flap gate on the waterside (WS) end. Brass cap No. 90 bench mark (BM) on the headwall on the landside (LS). [Additional Reference(s): DWR Levee Log, 2002. USACE San Joaquin O&M Manual 601.1, 1967, (HLM 4.16)]. FS Date: 4/8/2014

Concrete headwall and 48-inch flapgate visible on WS toe.

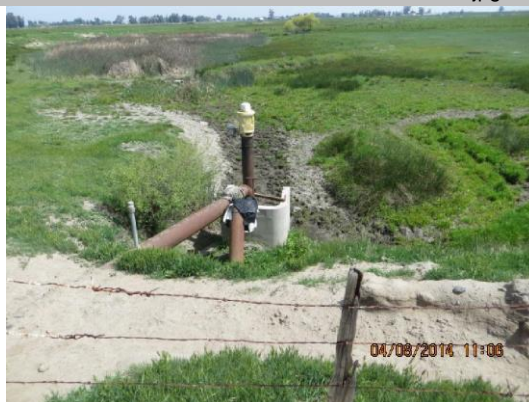
Photo 2 of 3 : UCIP\_SP\_2019\_39134\_60731.jpg

Assumed pipe exists under pump at LS toe.

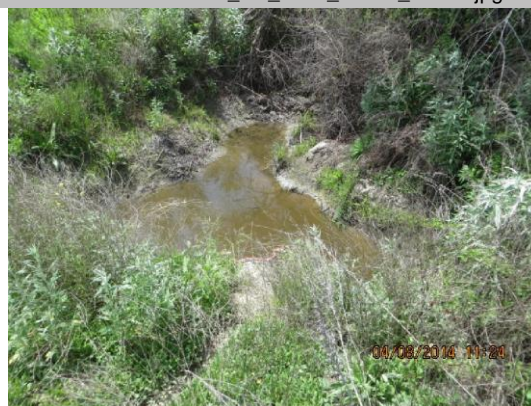
Photo 1 of 3 : UCIP\_SP\_2019\_39140\_60733.jpg

Comment Code					
Inspector Comment					
FS_ID:39140 DS_ID:19608 EP_NO: N/A Repair Type: Non-Urgent Crossing Status: Found UCIP Comments: 04/08/2014 Dense vegetation and fence limits the inspector's visibility to identify signs of pipe failure (leaks) along the landward side. Recommend obtaining access to landward toe and removing vegetation along pipe alignment to conduct proper inspection of structure and appurtenances. (DWR UCIP - W. Wylie) FIELD_STRUCT_DESC: 24-inch corrugated metal gravity drainage pipe through the levee, 11.9 feet below the crown. Flap gate on the waterside (WS) end. Brass cap No. 90 bench mark (BM) on the headwall on the landside (LS). [Additional Reference(s): DWR Levee Log, 2002. USACE San Joaquin O&M Manual 601.1, 1967, (HLM 4.27)]. FS Date: 4/8/2014

Pipe, flapgate, and headwall visible at WS toe.

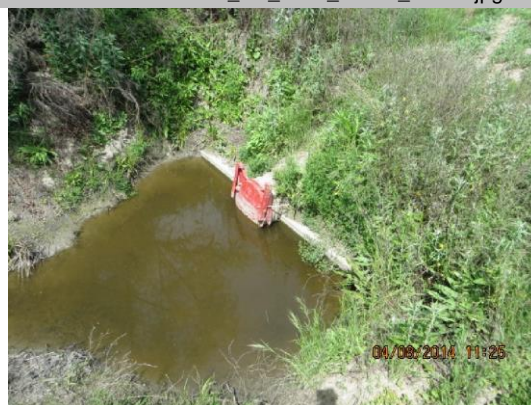
Photo 2 of 3 : UCIP\_SP\_2019\_39140\_60732.jpg

Pipe, flapgate, and headwall visible at WS toe.

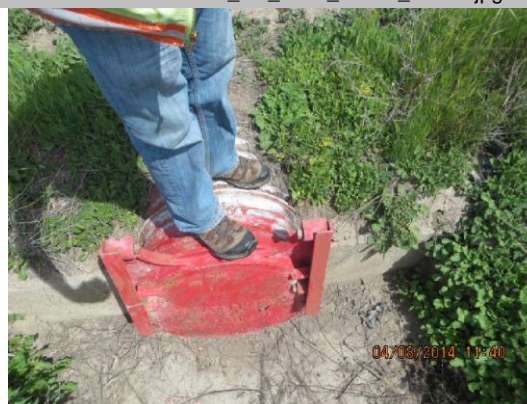
Photo 2 of 2 : UCIP\_SP\_2019\_39143\_60739.jpg

Flapgate and headwall visible at WS toe.

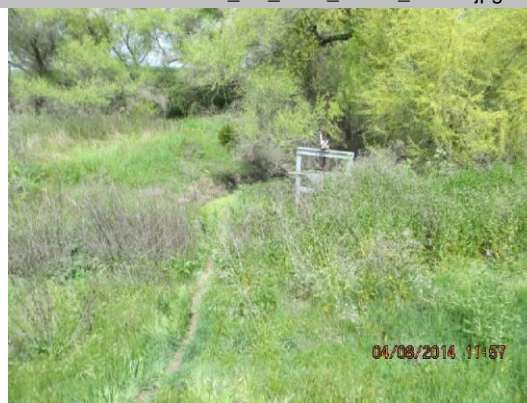
Photo 1 of 3 : UCIP\_SP\_2019\_39152\_60745.jpg

Comment Code						
Inspector Comment						
FS_ID:39152 DS_ID:19612 EP_NO: N/A Repair Type: Non-Urgent Crossing Status: Found UCIP Comments: 04/08/2014 Dense vegetation limits the inspector's visibility to identify signs of pipe failure (leaks) along waterward and landward slopes. Recommend removing vegetation along pipe alignment to conduct proper inspection of structure and appurtenances. Pipe completely blocked by soil on LS toe due to animal activity. Slide gate blocked open. (DWR UCIP - W. Wylie) FIELD_STRUCT_DESC: 48-inch corrugated metal gravity drainage pipe through the levee, 13.1 feet below the crown. Walkway to slide gate at the concrete headwall on the landside (LS) toe. Flap gate at the concrete headwall on the waterside (WS) toe. Brass cap No. 90 bench mark (BM) on the headwall on the LS. Pipe crosses the levee at an angle. [Additional Reference(s): DWR Levee Log, 2002. USACE San Joaquin O&M Manual 601.1, 1967, (HLM 6.13)]. FS Date: 4/8/2014

Slidegate at LS toe.

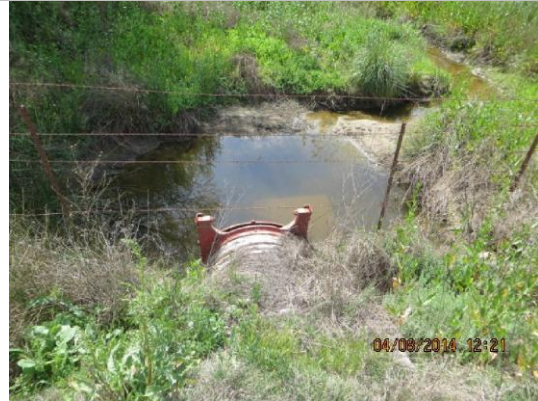
Photo 1 of 3 : UCIP\_SP\_2019\_50077\_60768.jpg

Comment Code						
Inspector Comment						
FS_ID:50077 DS_ID:19615 EP_NO: N/A Repair Type: Non-Urgent Crossing Status: Found UCIP Comments: 7/19/2016 Potential LS slope damage--difficult to determine due to dense vegetation. Limited access on WS toe due to wire fence. (DWR UCIP - O. Magana)4/08/2014 Slide gate blocked by debris at LS toe. Flapgate won't close because of debris. Dense vegetation limits the inspector's visibility to identify signs of pipe failure (leaks) along the slope. Recommend removing vegetation along pipe alignment to conduct proper inspection of structure and appurtenances. (DWR UCIP - W. Wylie) FIELD_STRUCT_DESC: 36-inch corrugated metal gravity drainage pipe through the levee, 10.3 feet below the crown. Slide gate on the landside (LS) toe. Flap gate on the waterside (WS) end. Brass cap No. 90 bench mark (BM) on the headwall on the LS. [Additional Reference(s): DWR Levee Log, 2002. USACE San Joaquin O&M Manual 601.1, 1967, (HLM 6.90)]. FS Date: 7/19/2016

Pipe, headwall, and flapgate on WS toe.

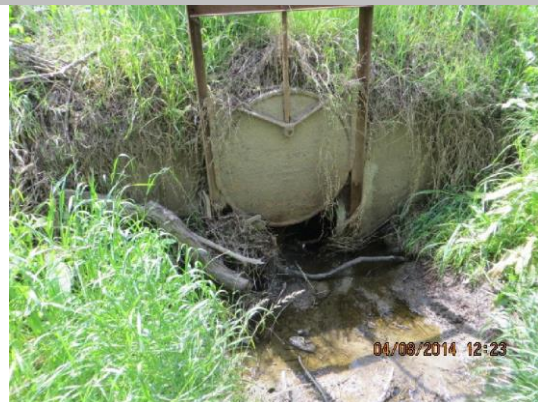
Photo 2 of 3 : UCIP\_SP\_2019\_50077\_60767.jpg

Pipe, concrete headwall, and slidegate on LS toe. Debris blocking closure of slidegate.

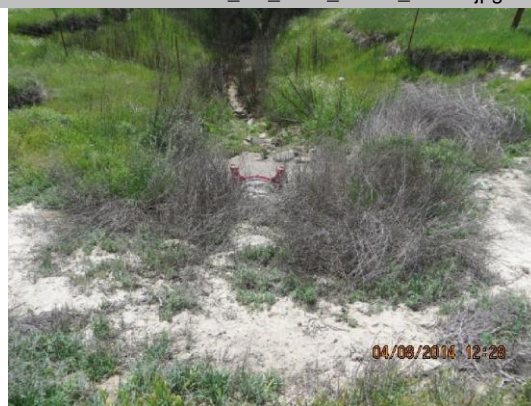
Photo 1 of 3 : UCIP\_SP\_2019\_53412\_60770.jpg

Comment Code					
Inspector Comment					
FS_ID:53412 DS_ID:19616 EP_NO: N/A Repair Type: Urgent Crossing Status: Found UCIP Comments: 11/01/2018 Pipe continues to corrode through. Voids (undermining) along pipe invert are visible from the LS. Potential undermining caused by erosion under concrete apron on the WS. Crossing remains Urgent due to the pipe failure. (O. Magana - DWR UCIP)04/08/2014 Pipe failing and corroded through at LS toe. Need to contact owner to determine status of crossing. Also dense vegetation limits the inspector's visibility to identify signs of pipe failure (leaks) along the landward slope. Recommend removing vegetation along pipe alignment to conduct proper inspection of structure. (DWR UCIP - W. Wylie) FIELD_STRUCT_DESC: 24-inch corrugated metal gravity drainage pipe through the levee, 5.1 feet below the crown. Flap gate on the waterside (WS) end. Brass cap No. 90 bench mark (BM) on the headwall on the landside (LS). [Additional Reference(s): DWR Levee Log, 2002. USACE San Joaquin O&M Manual 601.1, 1967, (HLM 7.21)]. FS Date: 11/1/2018 1:02:00 PM

Pipe, concrete headwall, and flapgate on WS toe.

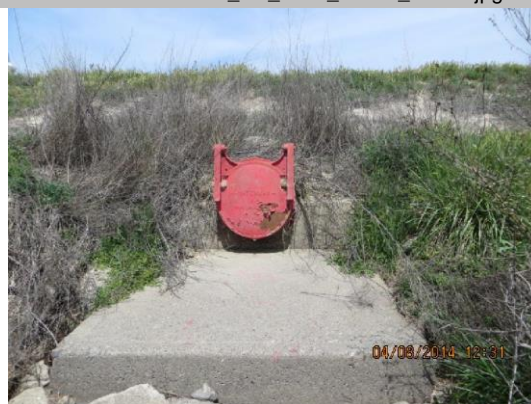
Photo 2 of 3 : UCIP\_SP\_2019\_53412\_60772.jpg

Flapgate and concrete headwall on WS toe.

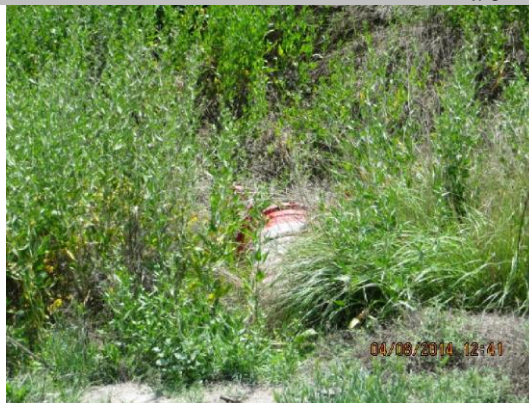
Photo 1 of 3 : UCIP\_SP\_2019\_39161\_60778.jpg

Comment Code					
Inspector Comment					
FS_ID:39161 DS_ID:19618 EP_NO: N/A Repair Type: Non-Urgent Crossing Status: Found UCIP Comments: 04/08/2014 Dense vegetation limits the inspector's visibility to identify signs of pipe failure (leaks) along the slope. Recommend removing vegetation along pipe alignment to conduct proper inspection of structure and appurtenances. (DWR UCIP - W. Wylie) FIELD_STRUCT_DESC: 24-inch corrugated metal gravity drainage pipe through the levee, 8 feet below the crown. Flap gate on the waterside (WS) end. Brass cap No. 80 bench mark (BM) on the headwall on the landside (LS). [Additional Reference(s): DWR Levee Log, 2002. USACE San Joaquin O&M Manual 601.1, 1967, (HLM 7.46)]. FS Date: 4/8/2014

Pipe and flapgate visible on WS toe.

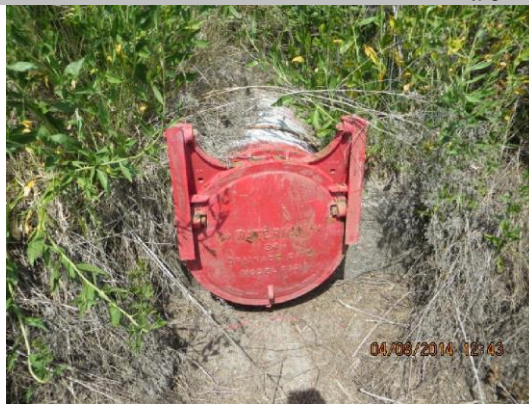
Photo 2 of 3 : UCIP\_SP\_2019\_39161\_60780.jpg

Pipe and flapgate visible on WS toe.

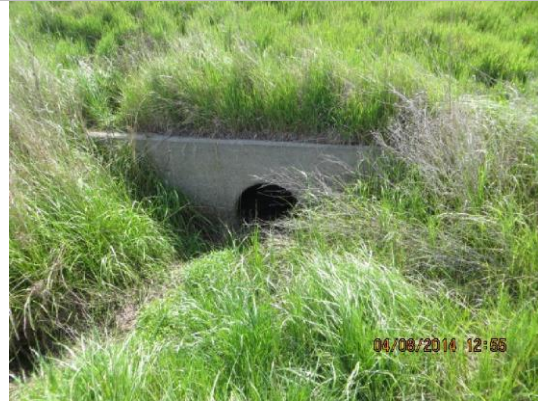
Photo 3 of 3 : UCIP\_SP\_2019\_39244\_60846.jpg

Comment Code						
Inspector Comment						
FS_ID:39244						
DS_ID:19620						
EP_NO: N/A						
Repair Type: Non-Urgent						
Crossing Status: Found						
UCIP Comments: 04/09/2014 Dense vegetation limits the inspector's visibility to identify signs of pipe failure (leaks) along the slope. Recommend removing vegetation along pipe alignment to conduct proper inspection of structure. (DWR UCIP - W. Wylie)						
FIELD_STRUCT_DESC: 24-inch corrugated metal gravity drainage pipe through the levee, 8 feet below the crown. Flap gate on the waterside (WS) end. Brass cap No. 80 bench mark (BM) on the headwall on the landside (LS). [Additional Reference(s): DWR Levee Log, 2002. USACE San Joaquin O&M Manual 601.1, 1967, (HLM 8.07)].						
FS Date: 4/9/2014

Pipe and concrete headwall on LS toe.

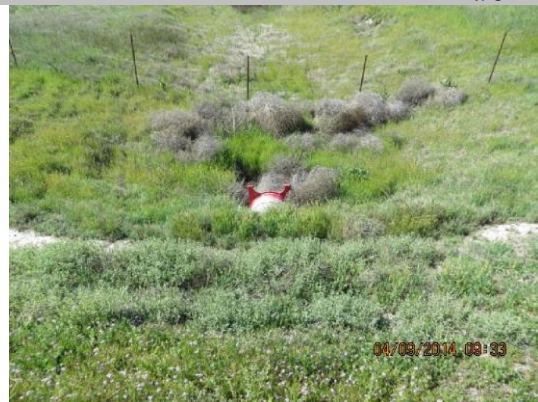
Photo 1 of 3 : UCIP\_SP\_2019\_39245\_60850.jpg

Comment Code						
Inspector Comment						
FS_ID:39245 DS_ID:19621 EP_NO: N/A Repair Type: Non-Urgent Crossing Status: Found UCIP Comments: 04/09/2014 Dense vegetation limits the inspector's visibility to identify signs of pipe failure (leaks) along the slope. Recommend removing vegetation along pipe alignment to conduct proper inspection of structure. Sediment buildup at landward toe. (DWR UCIP - W. Wylie) FIELD_STRUCT_DESC: 24-inch corrugated metal gravity drainage pipe through the levee, 9.5 feet below the crown. Flap gate on the waterside (WS) end. Brass cap No. 80 bench mark (BM) on the headwall on the landside (LS). [Additional Reference(s): DWR Levee Log, 2002. USACE San Joaquin O&M Manual 601.1, 1967, (HLM 8.41)]. FS Date: 4/9/2014

Concrete headwall, pipe, and flapgate at WS toe.

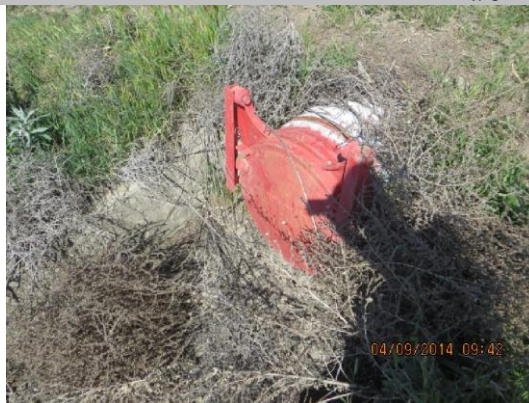
Photo 2 of 3 : UCIP\_SP\_2019\_39246\_60855.jpg

LM Start	8.57	Rating **	A/W	Issue No.	1220 (cont)	
LM End	8.57	Issue Type +	Ma	Location *		
Category	Supplemental			GPS Latitude/Longitude		
				Start	End	
Item	DWR UCIP LMA Responsibility			37.296552 °	37.296552 °	
				-120.858596 °	-120.858596 °	
DWR ID	19622					
Comment Code						
Inspector Comment						
FS_ID:39246						
DS_ID:19622						
EP_NO: N/A						
Repair Type: No Action Needed						
Crossing Status: Found						
UCIP Comments:						
FIELD_STRUCT_DESC: 24-inch corrugated metal gravity drainage pipe						
through the levee, 9 feet below the crown. Flap gate on the waterside						
(WS) end. Brass cap No. 80 bench mark (BM) on the headwall on the						
landside (LS). [Additional Reference(s): DWR Levee Log, 2002. USACE						
San Joaquin O&M Manual 601.1, 1967, (HLM 8.61)].						
FS Date: 4/9/2014

Pipe, Flapgate, and headwall on WS toe.

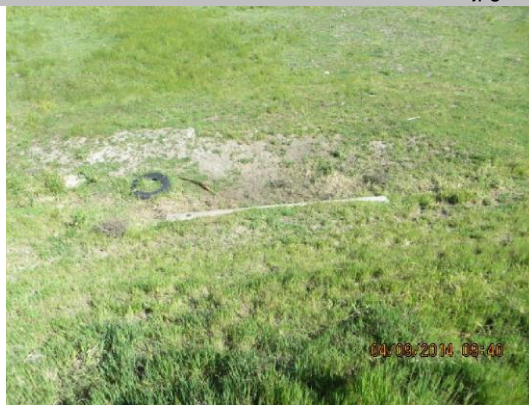
Photo 3 of 3 : UCIP\_SP\_2019\_39246\_60853.jpg

Pipe and headwall at LS toe.

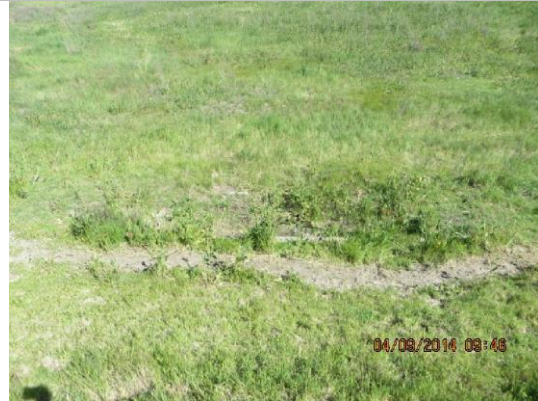
Photo 3 of 3 : UCIP\_SP\_2019\_39247\_60858.jpg

Comment Code						
Inspector Comment						
FS_ID:39247 DS_ID:19623 EP_NO: N/A Repair Type: Non-Urgent Crossing Status: Found UCIP Comments: 04/09/2014 Dense vegetation limits the inspector's visibility to identify signs of pipe failure (leaks) along the slope. Recommend removing vegetation along pipe alignment to conduct proper inspection of structure. (DWR UCIP - W. Wylie) FIELD_STRUCT_DESC: 24-inch corrugated metal gravity drainage pipe through the levee, 9.1 feet below the crown. Flap gate on the waterside (WS) end. Brass cap No. 80 bench mark (BM) on the headwall on the landside (LS). [Additional Reference(s): DWR Levee Log, 2002. USACE San Joaquin O&M Manual 601.1, 1967, (HLM 8.93)]. FS Date: 4/9/2014

Pipe and headwall visible on LS toe.

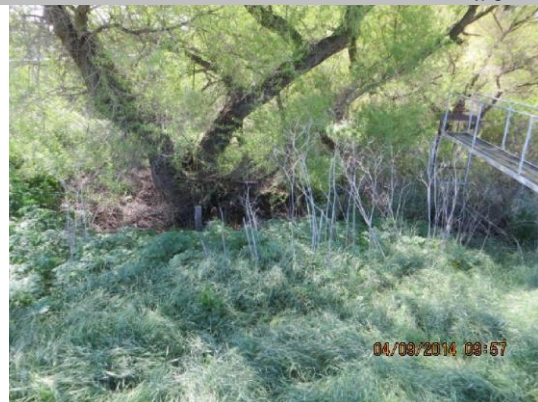
Photo 1 of 3 : UCIP\_SP\_2019\_39249\_60870.jpg

Comment Code						
Inspector Comment						
FS_ID:39249 DS_ID:19625 EP_NO: N/A Repair Type: Non-Urgent Crossing Status: Found UCIP Comments: 04/09/2014 Dense vegetation limits the inspector's visibility to identify signs of pipe failure (leaks) along the slope. Recommend removing vegetation along pipe alignment to conduct proper inspection of structure. Some sediment buildup in pipe. (DWR UCIP - W. Wylie) FIELD_STRUCT_DESC: 36-inch corrugated metal gravity drainage pipe through the levee, 10 feet below the crown. Flap gate on the waterside (WS) end. Brass cap No. 80 bench mark (BM) on the headwall on the landside (LS). [Additional Reference(s): DWR Levee Log, 2002. USACE San Joaquin O&M Manual 601.1, 1967, (HLM 9.00)]. FS Date: 4/9/2014

Pipe and flapgate visible on WS toe.

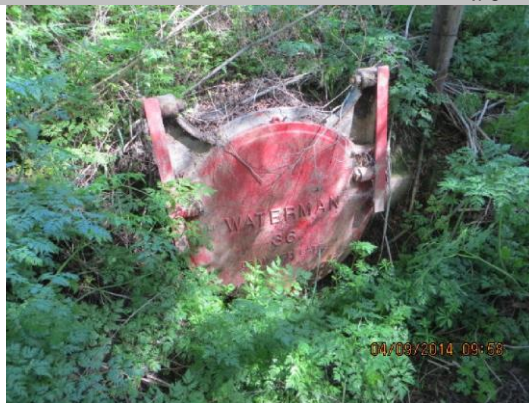
Photo 2 of 3 : UCIP\_SP\_2019\_39249\_60869.jpg

Comment Code						
Inspector Comment						
FS_ID:39249						
DS_ID:19625						
EP_NO: N/A						
Repair Type: Non-Urgent						
Crossing Status: Found						
UCIP Comments: 04/09/2014 Dense vegetation limits the inspector's visibility to identify signs of pipe failure (leaks) along the slope. Recommend removing vegetation along pipe alignment to conduct proper inspection of structure. Some sediment buildup in pipe. (DWR UCIP - W. Wylie)						
FIELD_STRUCT_DESC: 36-inch corrugated metal gravity drainage pipe through the levee, 10 feet below the crown. Flap gate on the waterside (WS) end. Brass cap No. 80 bench mark (BM) on the headwall on the landside (LS). [Additional Reference(s): DWR Levee Log, 2002. USACE San Joaquin O&M Manual 601.1, 1967, (HLM 9.00)].						
FS Date: 4/9/2014

Pipe and flapgate visible on WS toe.

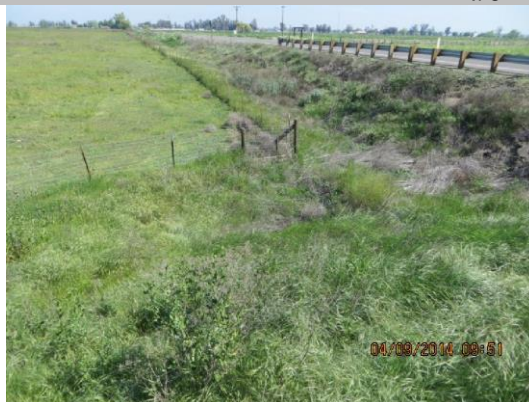
Photo 3 of 3 : UCIP\_SP\_2019\_39249\_60868.jpg

Pipe and headwall visible on LS toe.

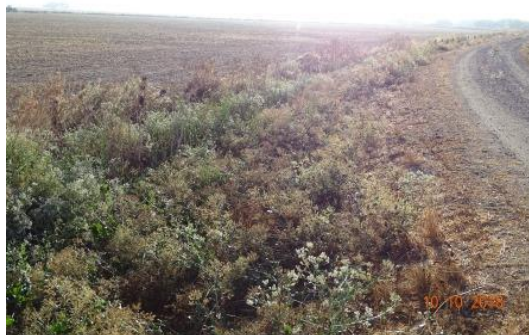
Photo 1 of 3 : SP\_2019\_NA0010\_118\_6\_20190307\_00004.jpg

Looking upstream at vegetation along landside slope. (Fall 2018)

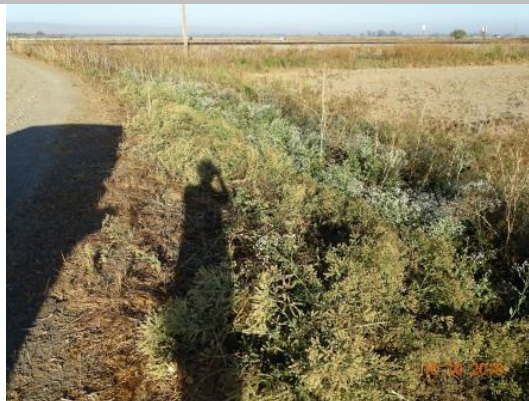
Photo 2 of 3 : SP\_2019\_NA0010\_118\_6\_20190307\_00005.jpg

Looking downstream at vegetation along landside slope. (Fall 2018)

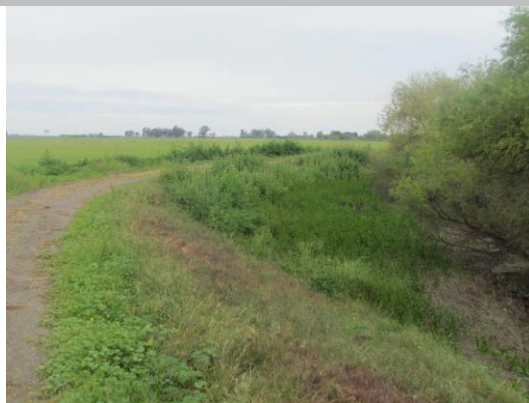
Photo 2 of 2 : SP\_2019\_NA0010\_118\_92\_20190307\_00016.jpg

LM Start	8.99	Rating **	U	Issue No.	92
LM End	9.66	Issue Type +	Ma	Location *	WS
Category	Earthen Levee			GPS Latitude/Longitude	
				Start	End
Item	Vegetation			37.297497 °	37.294588 °
				-120.851068 °	-120.840390 °
DWR ID	DWR_NA0010_01_s_2017_92				
Comment Code					
V2 : Remove the wild growth other than native grasses from the levee slopes.					
Inspector Comment					
Dense vegetation along waterside slope.

Looking southwest at dense veg on waterward slope.

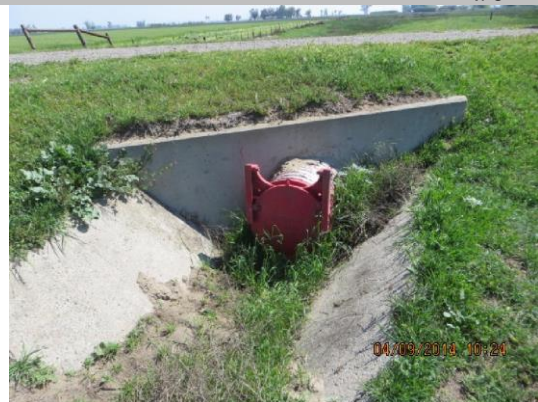
Photo 1 of 1 : UCIP\_SP\_2019\_33683\_60880.jpg

LM Start	9.64	Rating **	A/W	Issue No.	1226	
LM End	9.64	Issue Type +	Ma	Location *		
Category	Supplemental			GPS Latitude/Longitude		
				Start	End	
Item	DWR UCIP LMA Responsibility			37.294845 °	37.294845 °	
				-120.840580 °	-120.840580 °	
DWR ID	19628					
Comment Code						
Inspector Comment						
FS_ID:33683						
DS_ID:19628						
EP_NO: N/A						
Repair Type: No Action Needed						
Crossing Status: Found						
UCIP Comments:						
FIELD_STRUCT_DESC: 24-inch corrugated metal gravity drainage pipe through the levee, 4.5 feet below the crown. Flap gate on the waterside (WS) end. Brass cap No. 80 bench mark (BM) on the headwall on the landside (LS). [Additional Reference(s): DWR Levee Log, 2002. USACE San Joaquin O&M Manual 601.1, 1967, (HLM 9.67)].						
FS Date: 4/9/2014

Pipe, flapgate, and headwall visible on WS toe.

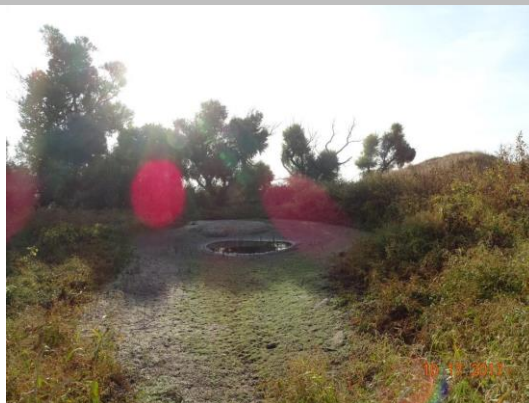
Photo 1 of 1 : SP\_2019\_NA0010\_118\_112\_20190307\_00030.jpg

LM Start	9.89	Rating **	A/W	Issue No.	112
LM End	9.90	Issue Type +	Ma	Location *	CR
Category	Earthen Levee			GPS Latitude/Longitude	
				Start	End
Item	Erosion / Bank Caving			37.291796 °	37.291581 °
				-120.839497 °	-120.839718 °
DWR ID	DWR_NA0010_01_f_2017_112				
Comment Code					
Inspector Comment					
Landowner degraded levee in the 1970's because Water on LS was flooding his property. Landowner has prevented efforts to restore levee. LMA has stated that no water from the waterside of the levee has ever backed up through the degraded levee and caused flooding.

Looking south at the levee bank caving. (Fall 2017)

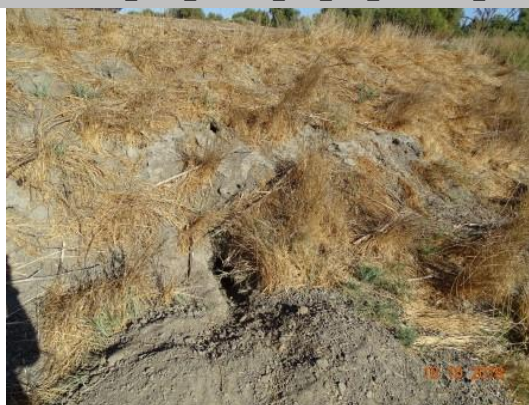
Photo 1 of 2 : SP\_2019\_NA0010\_118\_120\_20190307\_00039.jpg

LM Start	9.94	Rating **	U	Issue No.	120
LM End	9.97	Issue Type +	Ma	Location *	LS
Category	Earthen Levee			GPS Latitude/Longitude	
				Start	End
Item	Animal Control			37.290994 °	37.290673 °
				-120.839758 °	-120.839988 °
DWR ID	DWR_NA0010_01_f_2018_120				
Comment Code					
A3 : No rodents visible, but rodent burrows visible; need to backfill and compact or grout burrows.					
Inspector Comment					
Rodent burrows observed in this section with large amount of material displaced.

Representative view of rodent burrow. (Fall 2018)

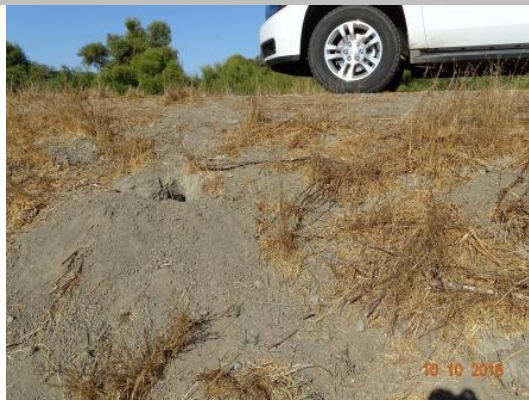
Photo 2 of 2 : SP\_2019\_NA0010\_118\_120\_20190307\_00040.jpg

View of another rodent burrow. (Fall 2018)

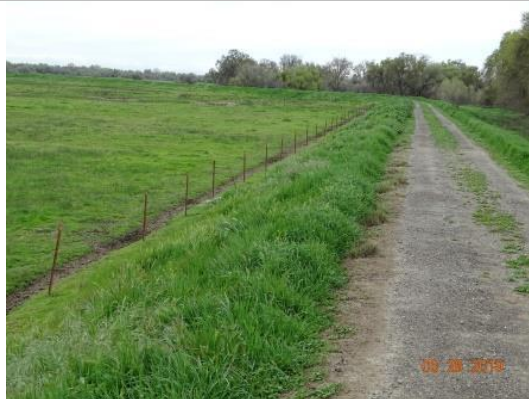
Photo 1 of 1 : SP\_2019\_NA0010\_118\_111\_20190402\_00287.jpg

LM Start	9.94	Rating **	M	Issue No.	111
LM End	10.67	Issue Type +	Ma	Location *	LS
Category	Earthen Levee			GPS Latitude/Longitude	
				Start	End
Item	Vegetation			37.290991 °	37.283752 °
				-120.839754 °	-120.833588 °
DWR ID	DWR_NA0010_01_s_2019_111				
Comment Code					
V1 : Control annual grass and weeds on the levee slopes and easements.					
Inspector Comment

View of vegetation along landside slope looking upstream. (Spring 2019)

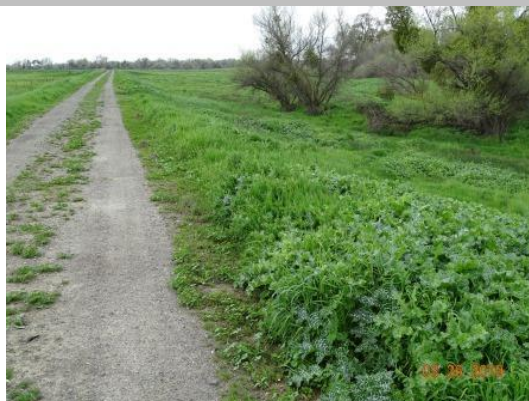
Photo 1 of 1 : SP\_2019\_NA0010\_118\_131\_20190402\_00292.jpg

LM Start	9.97	Rating **	U	Issue No.	131
LM End	10.53	Issue Type +	Ma	Location *	WS
Category	Earthen Levee			GPS Latitude/Longitude	
				Start	End
Item	Vegetation			37.290563 °	37.284409 °
				-120.840067 °	-120.836056 °
DWR ID	DWR_NA0010_01_s_2019_131				
Comment Code					
V1 : Control annual grass and weeds on the levee slopes and easements.					
Inspector Comment

View of waterside slope looking upstream. (Spring 2019)

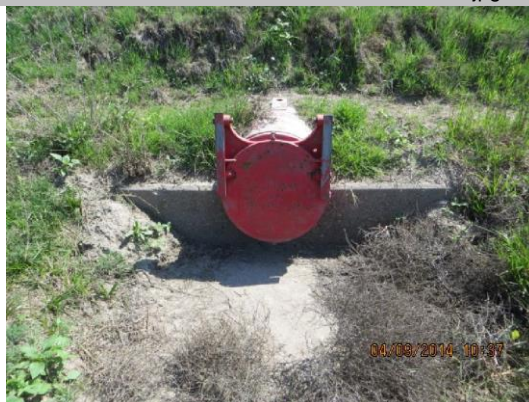
Photo 2 of 3 : UCIP\_SP\_2019\_39253\_60886.jpg

Pipe, headwall, and flapgate at WS toe.

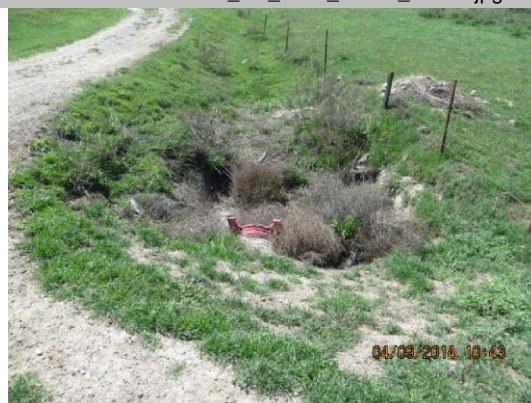
Photo 1 of 3 : UCIP\_SP\_2019\_33687\_60890.jpg

LM Start	10.68	Rating **	A/W	Issue No.	1228
LM End	10.68	Issue Type +	Ma	Location *	
Category	Supplemental			GPS Latitude/Longitude	
				Start	End
Item	DWR UCIP LMA Responsibility			37.283740 °	37.283740 °
				-120.833452 °	-120.833452 °
DWR ID	19630				
Comment Code					
Inspector Comment					
FS_ID:33687 DS_ID:19630 EP_NO: N/A Repair Type: No Action Needed Crossing Status: Found UCIP Comments: FIELD_STRUCT_DESC: 24-inch corrugated metal gravity drainage pipe through the levee, 7 feet below the crown. Flap gate on the waterside (WS) end. Brass cap No. 68 bench mark (BM) on the headwall on the landside (LS). [Additional Reference(s): DWR Levee Log, 2002. USACE San Joaquin O&M Manual 601.1, 1967, (HLM 10.72)]. FS Date: 4/9/2014

Pipe and flapgate on Ws toe.

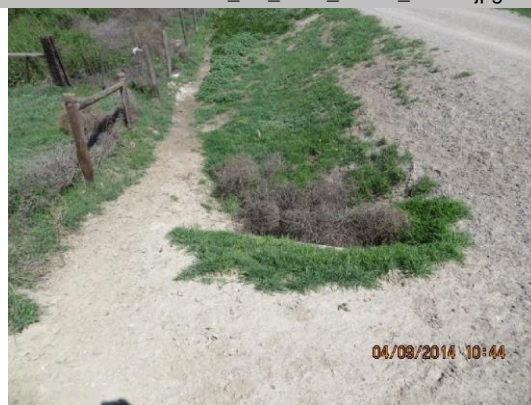
Photo 2 of 3 : UCIP\_SP\_2019\_33687\_60889.jpg

Pipe and headwall on LS toe.

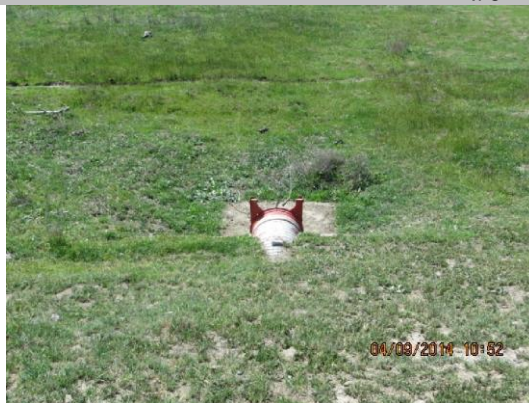
Photo 1 of 3 : UCIP\_SP\_2019\_39255\_60897.jpg

LM Start	10.98	Rating **	M	Issue No.	1230	
LM End	10.98	Issue Type +	Ma	Location *		
Category	Supplemental			GPS Latitude/Longitude		
				Start		End
Item	DWR UCIP LMA Responsibility			37.282627 °		37.282627 °
				-120.828233 °		-120.828233 °
DWR ID	19632					
Comment Code						
Inspector Comment						
FS_ID:39255 DS_ID:19632 EP_NO: N/A Repair Type: Non-Urgent Crossing Status: Found UCIP Comments: 04/09/2014 Dense vegetation blocks landward headwall. Recommend removing excess vegetation on landward toe. (DWR UCIP - W. Wylie) FIELD_STRUCT_DESC: 24-inch corrugated metal gravity drainage pipe through the levee, 6 feet below the crown. Flap gate on the waterside (WS) end. Brass cap No. 66 bench mark (BM) on the headwall on the landside (LS). [Additional Reference(s): DWR Levee Log, 2002. USACE San Joaquin O&M Manual 601.1, 1967, (HLM 11.00)]. FS Date: 4/9/2014

Pipe, headwall, and flapgate on WS toe.

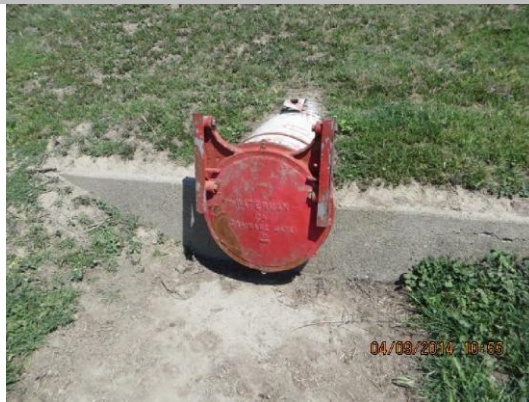
Photo 2 of 3 : UCIP\_SP\_2019\_39255\_60899.jpg

Pipe, headwall, and flapgate on WS toe.

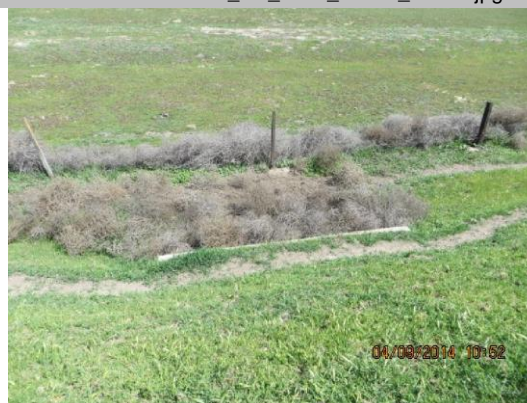
Photo 3 of 3 : UCIP\_SP\_2019\_39255\_60898.jpg

LM Start	10.98	Rating **	M	Issue No.	1230 (cont)
LM End	10.98	Issue Type +	Ma	Location *	
Category	Supplemental			GPS Latitude/Longitude	
				Start	End
Item	DWR UCIP LMA Responsibility			37.282627 °	37.282627 °
				-120.828233 °	-120.828233 °
DWR ID	19632				
Comment Code					
Inspector Comment					
FS_ID:39255 DS_ID:19632 EP_NO: N/A Repair Type: Non-Urgent Crossing Status: Found UCIP Comments: 04/09/2014 Dense vegetation blocks landward headwall. Recommend removing excess vegetation on landward toe. (DWR UCIP - W. Wylie) FIELD_STRUCT_DESC: 24-inch corrugated metal gravity drainage pipe through the levee, 6 feet below the crown. Flap gate on the waterside (WS) end. Brass cap No. 66 bench mark (BM) on the headwall on the landside (LS). [Additional Reference(s): DWR Levee Log, 2002. USACE San Joaquin O&M Manual 601.1, 1967, (HLM 11.00)]. FS Date: 4/9/2014

Pipe and headwall on LS toe.
