**Flood Control Project Maintenance  
Levee Inspections**

## Maintenance Issue Types Only, Levee Inspection Report By Mile - Spring 2019

### Lower San Joaquin Levee District

Waterway	Bank	Unit Miles	Inspection Start/End	Inspector
Unit No. 01 San Joaquin River	Right	22.52	03/26/2019 03/26/2019	Corey Fujitani

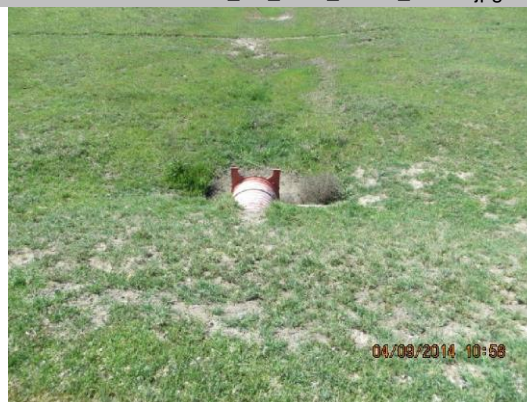
Photo 1 of 3 : UCIP\_SP\_2019\_33690\_60903.jpg

LM Start	11.14	Rating **	A/W	Issue No.	1231
LM End	11.14	Issue Type +	Ma	Location *	
Category	Supplemental			GPS Latitude/Longitude	
				Start	End
Item	DWR UCIP LMA Responsibility			37.281813 °	37.281813 °
				-120.825409 °	-120.825409 °
DWR ID	19633				
Comment Code					
Inspector Comment					
FS_ID:33690					
DS_ID:19633					
EP_NO: N/A					
Repair Type: No Action Needed					
Crossing Status: Found					
UCIP Comments:					
FIELD_STRUCT_DESC: 24-inch corrugated metal gravity drainage pipe through the levee, 5 feet below the crown. Flap gate on the waterside (WS) end. Brass cap No. 65 bench mark (BM) on the headwall on the landside (LS). [Additional Reference(s): DWR Levee Log, 2002. USACE San Joaquin O&M Manual 601.1, 1967, (HLM 11.18)].					
FS Date: 4/9/2014

Pipe, headwall, and flapgate on WS toe.

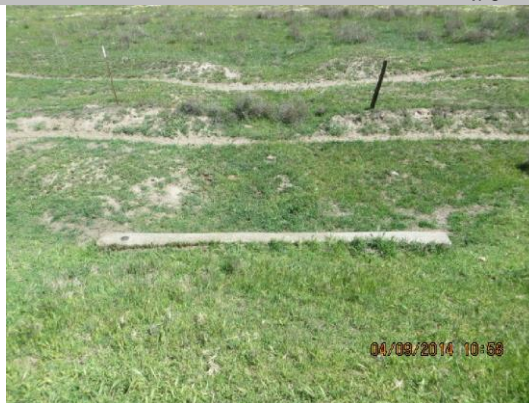
Photo 2 of 3 : UCIP\_SP\_2019\_33690\_60902.jpg

Pipe and headwall at LS toe.

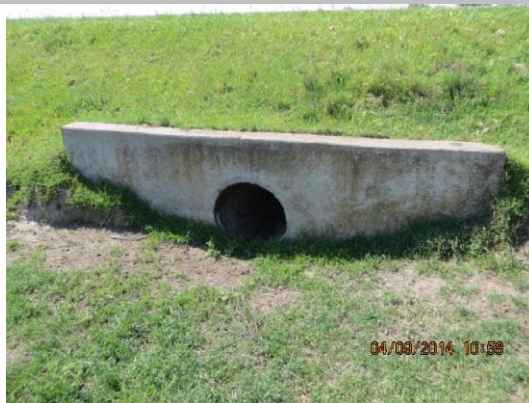
Photo 3 of 3 : UCIP\_SP\_2019\_33690\_60901.jpg

Pipe and headwall at LS toe.

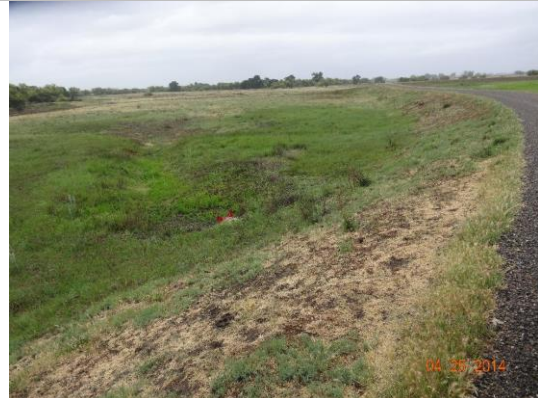
Photo 1 of 3 : UCIP\_SP\_2019\_36103\_65362.jpg

Comment Code					
Inspector Comment					
FS_ID:36103 DS_ID:19634 EP_NO: N/A Repair Type: Non-Urgent Crossing Status: Found UCIP Comments: 04/25/2014 Need to contact owner--landward side has been buried. It appears that soil was removed from levee toe, immediately upstream, and used to pile soil at landward side at crossing. (DWR UCIP - O. Magana) FIELD_STRUCT_DESC: 24-inch corrugated metal gravity drainage pipe through the levee, 10 feet below the crown. Flap gate on the waterside (WS) end. Brass cap No. 62 bench mark (BM) on the headwall on the landside (LS). [Additional Reference(s): DWR Levee Log, 2002. USACE San Joaquin O&M Manual 601.1, 1967, (HLM 11.48)]. FS Date: 4/25/2014

View of waterward side.

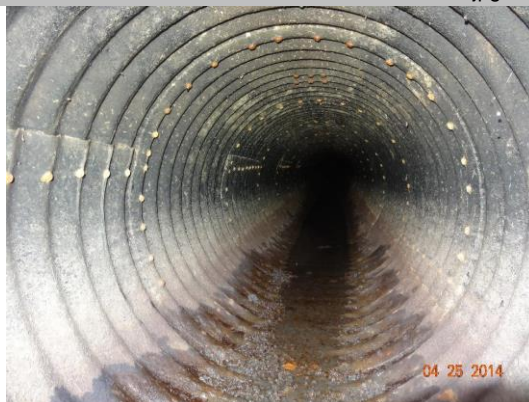
Photo 3 of 3 : UCIP\_SP\_2019\_36103\_65363.jpg

Inside view of pipe from waterward side.

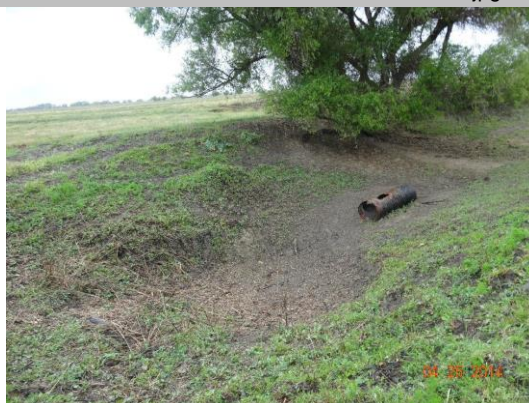
Photo 2 of 3 : UCIP\_SP\_2019\_36105\_65371.jpg

Landward side of crossing buried--damage pipe section visible on landward side.

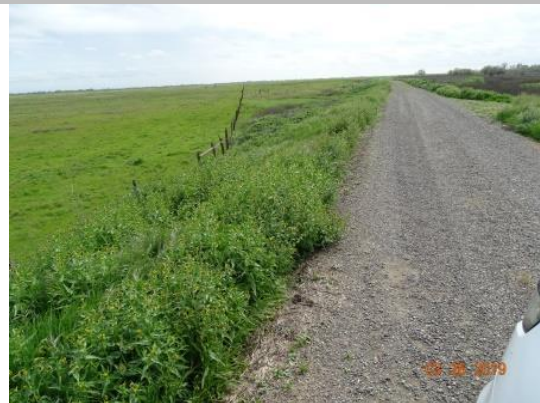
Photo 1 of 1 : SP\_2019\_NA0010\_118\_127\_20190402\_00288.jpg

LM Start	12.62	Rating **	U	Issue No.	127
LM End	17.44	Issue Type +	Ma	Location *	LS
Category	Earthen Levee			GPS Latitude/Longitude	
				Start	End
Item	Vegetation			37.258951 °	37.216002 °
				-120.826387 °	-120.779165 °
DWR ID	DWR_NA0010_01_f_2018_127				
Comment Code					
V1 : Control annual grass and weeds on the levee slopes and easements.					
Inspector Comment

View of landside slope looking upstream. (Spring 2019)

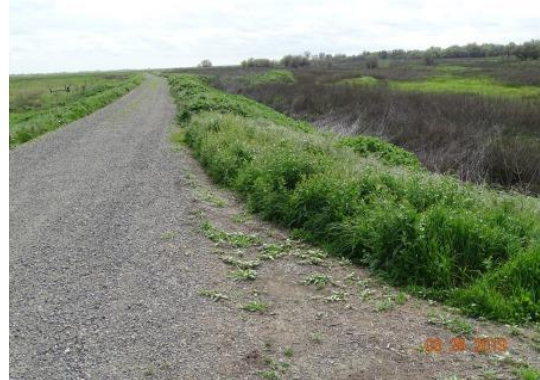
Photo 1 of 1 : SP\_2019\_NA0010\_118\_133\_20190402\_00289.jpg

LM Start	12.62	Rating **	U	Issue No.	133
LM End	17.44	Issue Type +	Ma	Location *	WS
Category	Earthen Levee	GPS Latitude/Longitude			
		Start		End	
Item	Vegetation	37.258950 °		37.216003 °	
		-120.826387 °		-120.779165 °	
DWR ID	DWR_NA0010_01_s_2019_133				
Comment Code					
V1 : Control annual grass and weeds on the levee slopes and easements.					
Inspector Comment

View of waterside slope looking upstream. (Spring 2019)

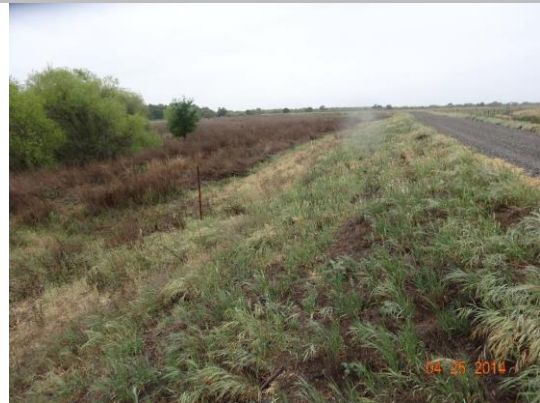
Photo 1 of 3 : UCIP\_SP\_2019\_36146\_65412.jpg

Comment Code						
Inspector Comment						
FS_ID:36146 DS_ID:19637 EP_NO: N/A Repair Type: Non-Urgent Crossing Status: Found UCIP Comments: 04/25/2014 Concrete headwall on landward side blocked by debris. Dense vegetation limits the inspector's visibility to identify signs of pipe failure (leaks) along the landward slope. Recommend removing vegetation along pipe alignment to conduct proper inspection of crossing. (DWR UCIP - O. Magana) FIELD_STRUCT_DESC: 24-inch corrugated metal gravity drainage pipe through the levee, 9.5 feet below the crown. Flap gate on the waterside (WS) end. Brass cap No. 60 bench mark (BM) on the headwall on the landside (LS). [Additional Reference(s): DWR Levee Log, 2002. USACE San Joaquin O&M Manual 601.1, 1967, (HLM 12.94)]. FS Date: 4/25/2014

View of waterward side.

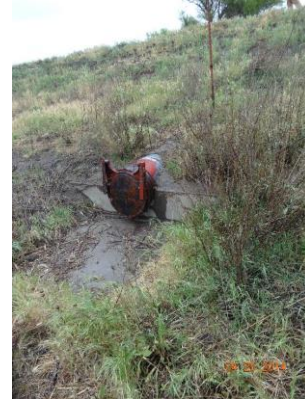
Photo 2 of 3 : UCIP\_SP\_2019\_36146\_65411.jpg

Flap gate and concrete headwall visible on waterward side.

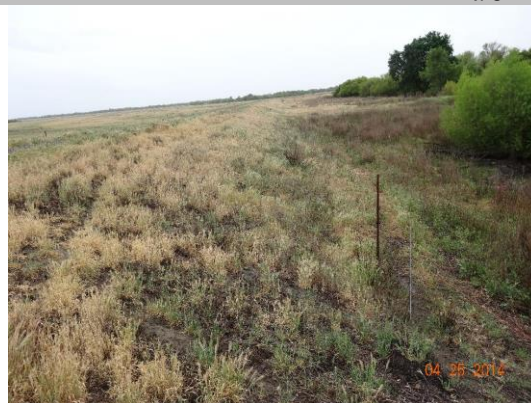
Photo 1 of 3 : UCIP\_SP\_2019\_39256\_65418.jpg

Comment Code						
Inspector Comment						
FS_ID:39256 DS_ID:19639 EP_NO: N/A Repair Type: Non-Urgent Crossing Status: Found UCIP Comments: 04/25/2014 No access to waterward toe due to fence. Unable to find the concrete headwall and flap gate on waterward side past fence. Also dense vegetation limits the inspector's visibility to identify signs of pipe failure (leaks) along the waterward slope. Recommend removing vegetation along pipe alignment to conduct proper inspection of structure. Also need access past fence on waterward side. (DWR UCIP - O. Magana) FIELD_STRUCT_DESC: 24-inch corrugated metal gravity drainage pipe through the levee, 14.5 feet below the crown. Flap gate on the waterside (WS) end. Brass cap No. 60 bench mark (BM) on the headwall on the landside (LS). [Additional Reference(s): DWR Levee Log, 2002. USACE San Joaquin O&M Manual 601.1, 1967, (HLM 13.58)]. FS Date: 4/25/2014

View of waterward side.

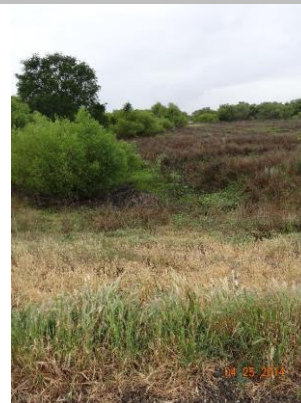
Photo 2 of 3 : UCIP\_SP\_2019\_39256\_65417.jpg

Dense vegetation on waterward side.

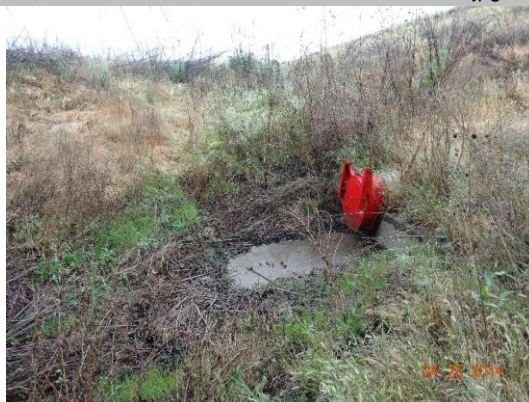
Photo 2 of 3 : UCIP\_SP\_2019\_36166\_65452.jpg

View of concrete headwall, concrete apron, and flap gate on waterward side.

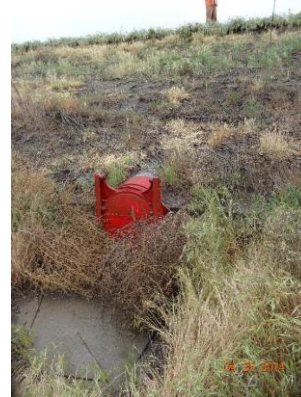
Photo 2 of 3 : UCIP\_SP\_2019\_36167\_65454.jpg

Flap gate, concrete headwall, and concrete apron located on waterward toe.

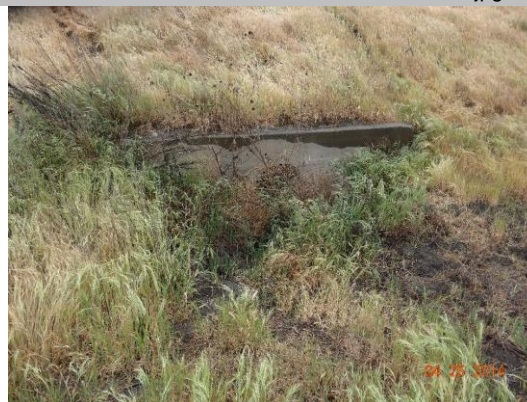
Photo 3 of 3 : UCIP\_SP\_2019\_36167\_65453.jpg

Concrete headwall located on landward toe.

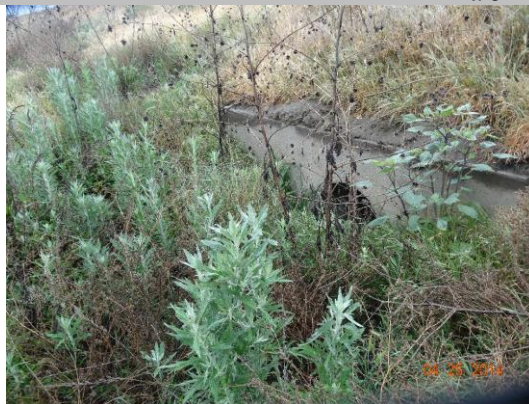
Photo 3 of 3 : UCIP\_SP\_2019\_36169\_65462.jpg

Concrete headwall visible on landward toe--dense vegetation blocking inlet.

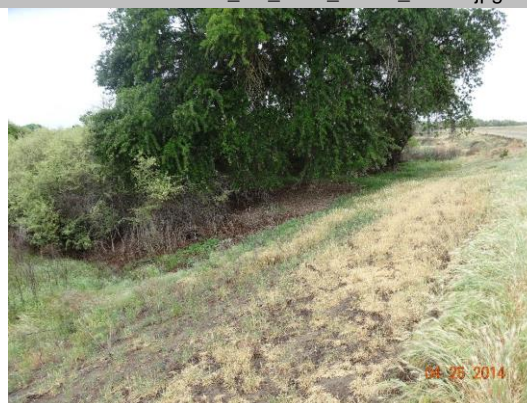
Photo 1 of 3 : UCIP\_SP\_2019\_36171\_65471.jpg

Comment Code						
Inspector Comment						
FS_ID:36171 DS_ID:19645 EP_NO: N/A Repair Type: Non-Urgent Crossing Status: Found UCIP Comments: 04/25/2014 Dense vegetation limits the inspector's visibility to identify signs of pipe failure (leaks) along the waterward and landward slope. Recommend removing vegetation along pipe alignment to conduct proper inspection of structure. (DWR UCIP - O. Magana) FIELD_STRUCT_DESC: 24-inch corrugated metal gravity drainage pipe through the levee, 11 feet below the crown. Flap gate on the waterside (WS) end. Brass cap No. 60 bench mark (BM) on the headwall on the landside (LS). [Additional Reference(s): DWR Levee Log, 2002. USACE San Joaquin O&M Manual 601.1, 1967, (HLM 15.81)]. FS Date: 4/25/2014

View of waterward side.

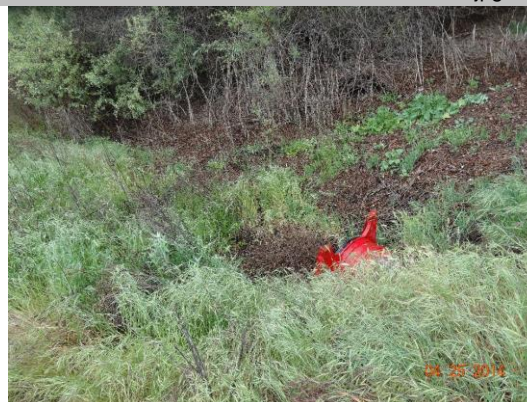
Photo 2 of 3 : UCIP\_SP\_2019\_36171\_65470.jpg

Flap gate visible on waterward side.

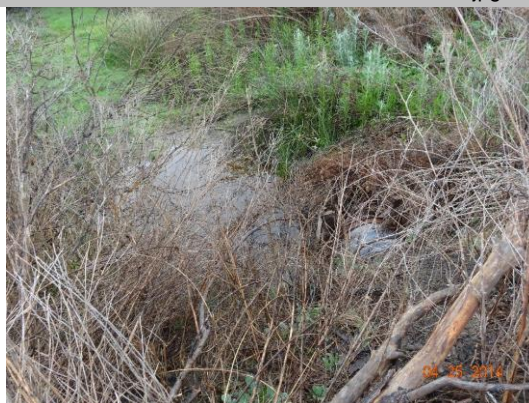
Photo 2 of 3 : UCIP\_SP\_2019\_39257\_65479.jpg

Crossing visible on waterward side under dense vegetation.

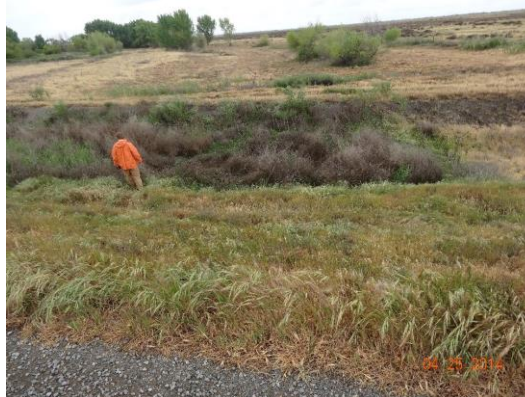
Photo 3 of 3 : UCIP\_SP\_2019\_39257\_65478.jpg

View of landward side.

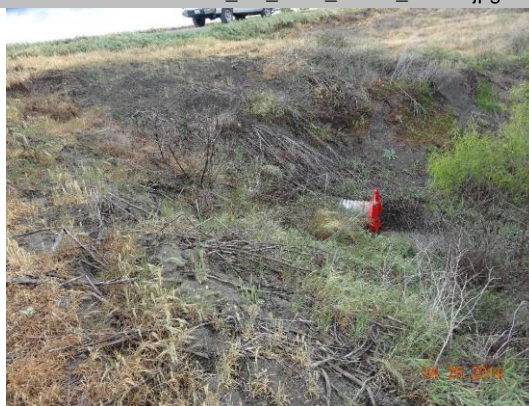
Photo 3 of 3 : UCIP\_SP\_2019\_39258\_66287.jpg

View of flap gate visible on waterward side.

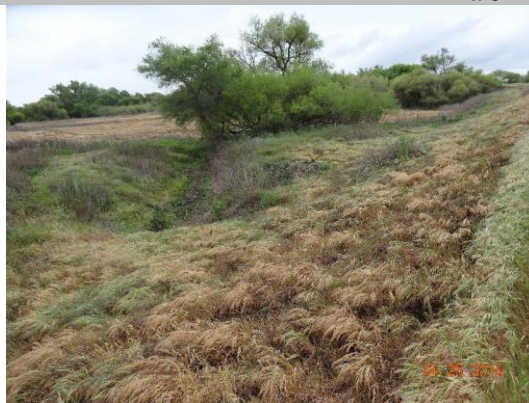
Photo 1 of 3 : UCIP\_SP\_2019\_39259\_65518.jpg

Comment Code						
Inspector Comment						
FS_ID:39259 DS_ID:19577 EP_NO: N/A Repair Type: Non-Urgent Crossing Status: Found UCIP Comments: 04/25/2014 Dense vegetation limits the inspector's visibility to identify signs of pipe failure (leaks) along the waterward and landward slopes. Concrete headwall is buried by dense vegetation. Recommend removing vegetation along pipe alignment to conduct proper inspection of structure. (DWR UCIP - O. Magana) FIELD_STRUCT_DESC: 24-inch corrugated metal gravity drainage pipe through the levee, 11.5 feet below the crown. Flap gate on the waterside (WS) end. Brass cap No. 50 bench mark (BM) on the headwall on the landside (LS). [Additional Reference(s): DWR Levee Log, 2002. USACE San Joaquin O&M Manual 601.1, 1967, (HLM 17.01)]. FS Date: 4/25/2014

View of waterward side.

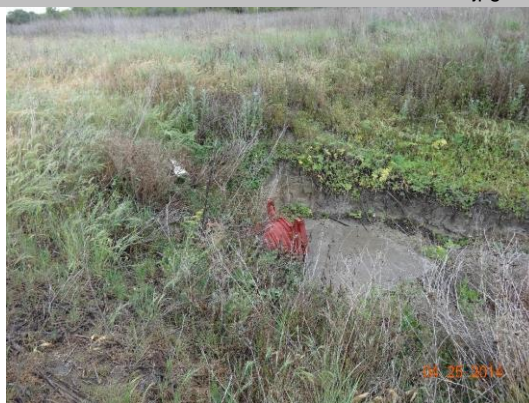
Photo 2 of 3 : UCIP\_SP\_2019\_39259\_65519.jpg

Flap gate visible on waterward side.

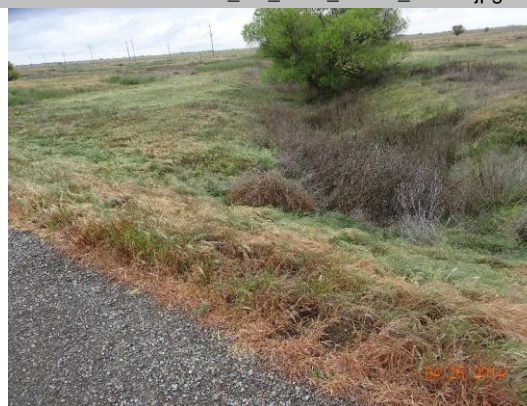
Photo 3 of 3 : UCIP\_SP\_2019\_39259\_65517.jpg

View of landward side.

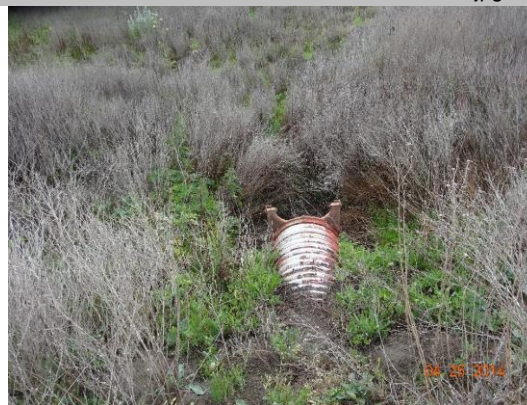
Photo 2 of 3 : UCIP\_SP\_2019\_39260\_65521.jpg

Pipe visible on waterward side.

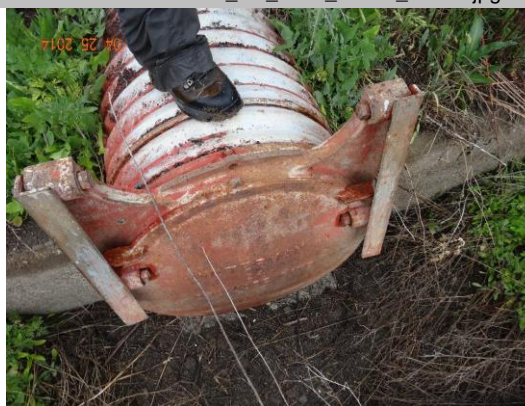
Photo 3 of 3 : UCIP\_SP\_2019\_39260\_65520.jpg

Flap gate visible on waterward toe.

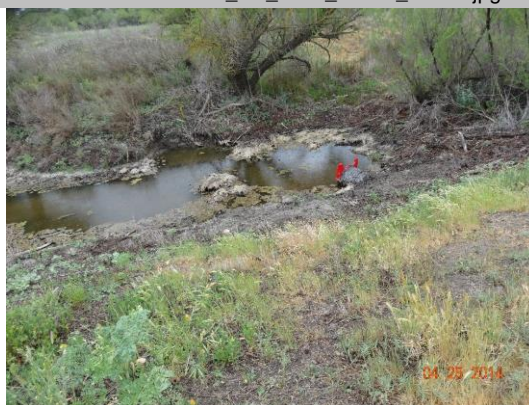
Photo 2 of 3 : UCIP\_SP\_2019\_36203\_65552.jpg

Pipe visible on waterward side.

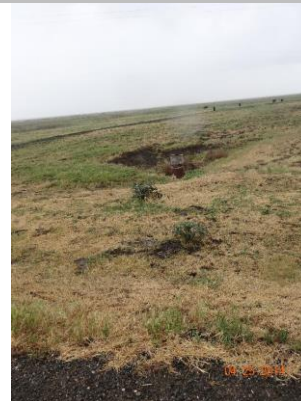
Photo 3 of 3 : UCIP\_SP\_2019\_39261\_65555.jpg

Item	DWR UCIP LMA Responsibility			37.210998 °		37.210998 °
				-120.768900 °		-120.768900 °
DWR ID	19581					
Comment Code						
Inspector Comment						
FS_ID:39261 DS_ID:19581 EP_NO: N/A Repair Type: Non-Urgent Crossing Status: Found UCIP Comments: 04/25/2014 Need to contact owner. Recommend investigating integrity of pipe wall through levee heavy corrosion visible from landward side. (DWR UCIP - O. Magana) FIELD_STRUCT_DESC: 24-inch corrugated metal gravity drainage pipe through the levee, 11.5 feet below the crown. Flap gate on the waterside (WS) end. Brass cap No. 50 bench mark (BM) on the headwall on the landside (LS). [Additional Reference(s): DWR Levee Log, 2002. USACE San Joaquin O&M Manual 601.1, 1967, (HLM 18.19)]. FS Date: 4/25/2014

View of landward side.

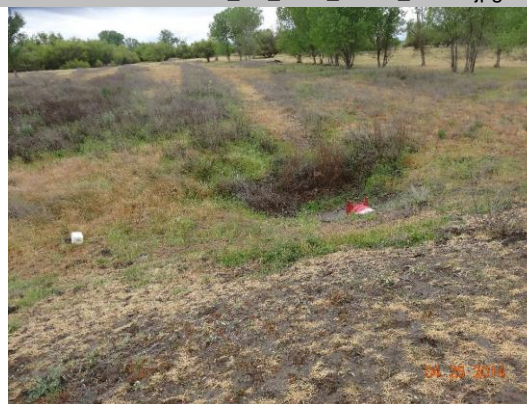
Photo 1 of 3 : UCIP\_SP\_2019\_36206\_65563.jpg

LM Start	18.45	Rating **	A/W	Issue No.	1254	
LM End	18.45	Issue Type +	Ma	Location *		
Category	Supplemental			GPS Latitude/Longitude		
				Start	End	
Item	DWR UCIP LMA Responsibility			37.207538 °	37.207538 °	
				-120.767679 °	-120.767679 °	
DWR ID	19582					
Comment Code						
Inspector Comment						
FS_ID:36206						
DS_ID:19582						
EP_NO: N/A						
Repair Type: No Action Needed						
Crossing Status: Found						
UCIP Comments:						
FIELD_STRUCT_DESC: 24-inch corrugated metal gravity drainage pipe through the levee, 9.4 feet below the crown. Flap gate on the waterside (WS) end. Brass cap No. 50 bench mark (BM) on the headwall on the landside (LS). [Additional Reference(s): DWR Levee Log, 2002. USACE San Joaquin O&M Manual 601.1, 1967, (HLM 18.45)].						
FS Date: 4/25/2014

View of waterward side.

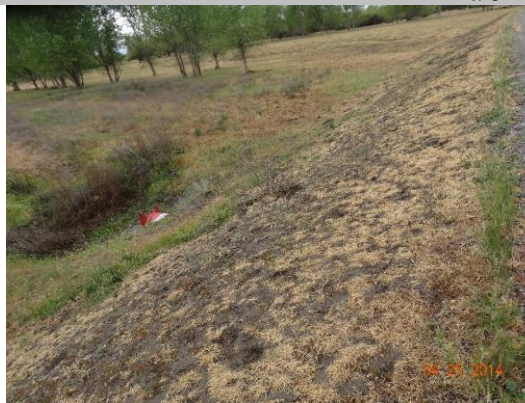
Photo 2 of 3 : UCIP\_SP\_2019\_36206\_65562.jpg

View of waterward slope.

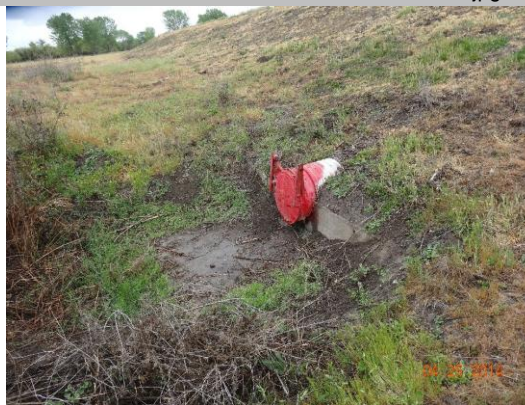
Photo 3 of 3 : UCIP\_SP\_2019\_36206\_65561.jpg

Flap gate visible on waterward side.

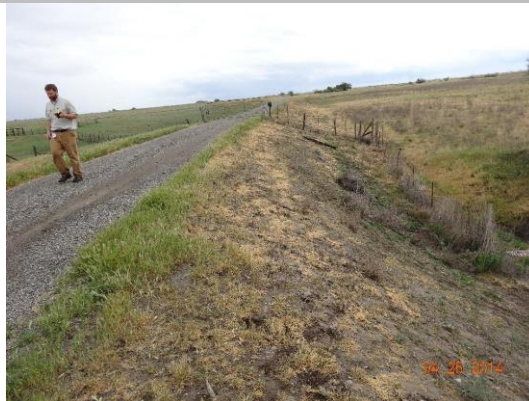
Photo 1 of 3 : UCIP\_SP\_2019\_36246\_65627.jpg

Comment Code					
Inspector Comment					
FS_ID:36246 DS_ID:19593 EP_NO: N/A Repair Type: Non-Urgent Crossing Status: Found UCIP Comments: 04/25/2014 Dense vegetation limits the inspector's visibility to identify signs of pipe failure (leaks) along the landward slope. Recommend removing vegetation along pipe alignment to conduct proper inspection of structure. (DWR UCIP - O. Magana) FIELD_STRUCT_DESC: 24-inch corrugated metal gravity drainage pipe through the levee, 12 feet below the crown. Flap gate on the waterside (WS) end. Brass cap No. 50 bench mark (BM) on the headwall on the landside (LS). [Additional Reference(s): DWR Levee Log, 2002. USACE San Joaquin O&M Manual 601.1, 1967, (HLM 18.79)]. FS Date: 4/25/2014

Overview of levee crown and waterward slope.

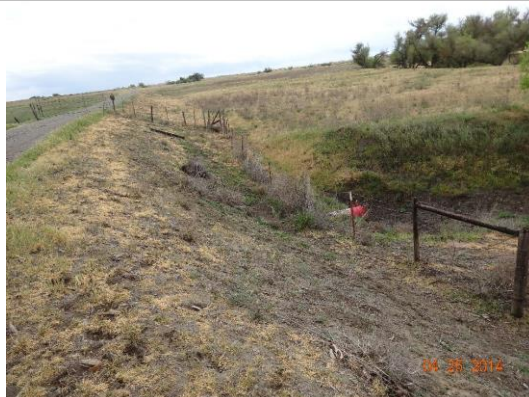
Photo 2 of 3 : UCIP\_SP\_2019\_36246\_65623.jpg

View of waterward side.

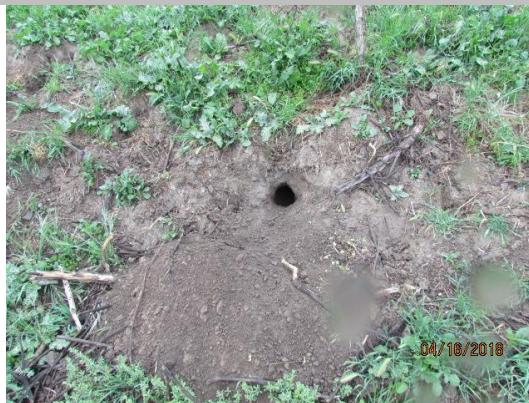
Photo 2 of 2 : SP\_2019\_NA0010\_118\_94\_20190307\_00018.jpg

LM Start	18.79	Rating **	U	Issue No.	94 (cont)	
LM End	18.79	Issue Type +	Ma	Location *	LS	
Category	Earthen Levee			GPS Latitude/Longitude		
				Start		End
Item	Animal Control			37.204913 °		37.204913 °
				-120.762412 °		-120.762412 °
DWR ID	DWR_NA0010_01_s_2018_94					
Comment Code						
A3 : No rodents visible, but rodent burrows visible; need to backfill and compact or grout burrows.						
Inspector Comment						
Several large rodent holes on landward slope.

Looking at typical view of rodent holes with this section. (Spring 2018)

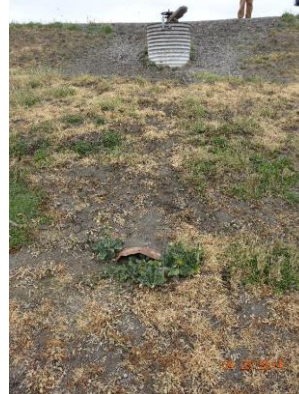
Photo 1 of 3 : UCIP\_SP\_2019\_39263\_65631.jpg

Comment Code						
Inspector Comment						
FS_ID:39263						
DS_ID:19594						
EP_NO: N/A						
Repair Type: Non-Urgent						
Crossing Status: Found						
UCIP Comments: 04/25/2014 Non-functional crossing--pipe is buried on waterward side. Sediment buildup in pipe visible from landward side. Need to coordinate with owner to determine status. If crossing is no longer in use, owner will need to coordinate with DWR Inspector and CVFPB to properly abandon. (DWR UCIP - O. Magana)						
FIELD_STRUCT_DESC: 24-inch corrugated metal gravity drainage pipe through the levee, 13 feet below the crown. Flap gate on the waterside (WS) end. Brass cap No. 40 bench mark (BM) on the headwall on the landside (LS). [Additional Reference(s): DWR Levee Log, 2002. USACE San Joaquin O&M Manual 601.1, 1967, (HLM 19.17)].						
FS Date: 4/25/2014

View of waterward slope. CMP riser and pipe visible.

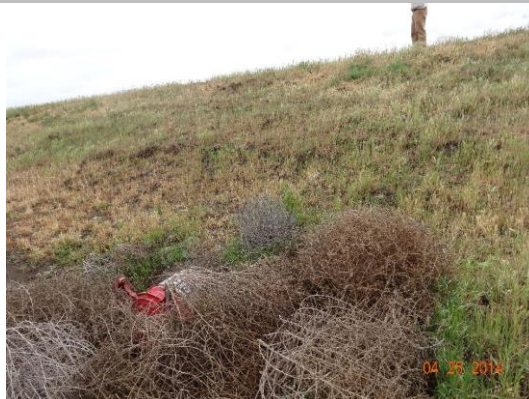
Photo 2 of 3 : UCIP\_SP\_2019\_39268\_65640.jpg

Flap gate visible on waterward side--potential erosion present on slope.

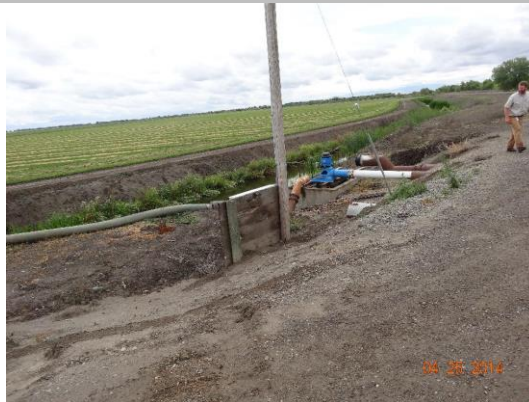
Photo 3 of 3 : UCIP\_SP\_2019\_39878\_66307.jpg

View of landward side.

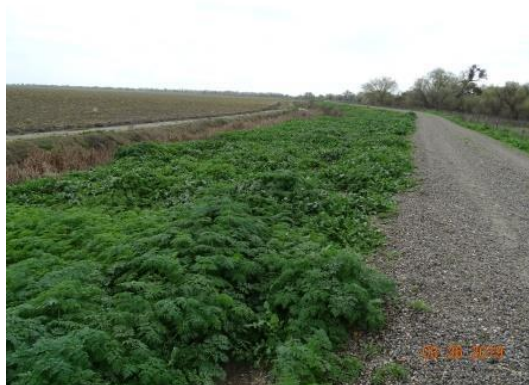
Photo 1 of 1 : SP\_2019\_NA0010\_118\_138\_20190402\_00291.jpg

LM Start	20.27	Rating **	U	Issue No.	138
LM End	20.37	Issue Type +	Ma	Location *	LS
Category	Earthen Levee			GPS Latitude/Longitude	
				Start	End
Item	Vegetation			37.193518 °	37.192227 °
				-120.760309 °	-120.761282 °
DWR ID	DWR_NA0010_01_s_2019_138				
Comment Code					
V1 : Control annual grass and weeds on the levee slopes and easements.					
Inspector Comment

View of landside slope looking upstream. (Spring 2019)

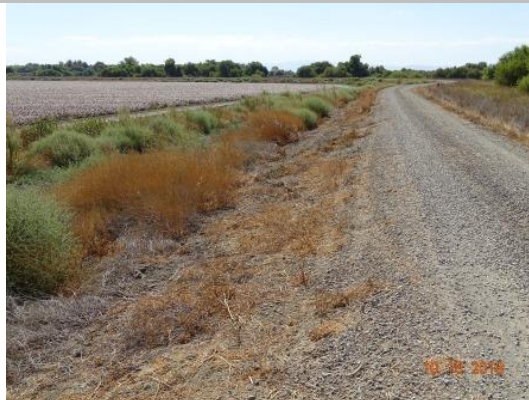
Photo 1 of 1 : SP\_2019\_NA0010\_118\_129\_20190307\_00042.jpg

LM Start	20.53	Rating **	M	Issue No.	129
LM End	22.01	Issue Type +	Ma	Location *	LS
Category	Earthen Levee			GPS Latitude/Longitude	
				Start	End
Item	Vegetation			37.190335 °	37.172720 °
				-120.762737 °	-120.754918 °
DWR ID	DWR_NA0010_01_f_2018_129				
Comment Code					
V1 : Control annual grass and weeds on the levee slopes and easements.					
Inspector Comment					
vegetation along landside slope and dense vegetation along the toe

View of vegetation on landside slope looking upstream. (Fall 2018)

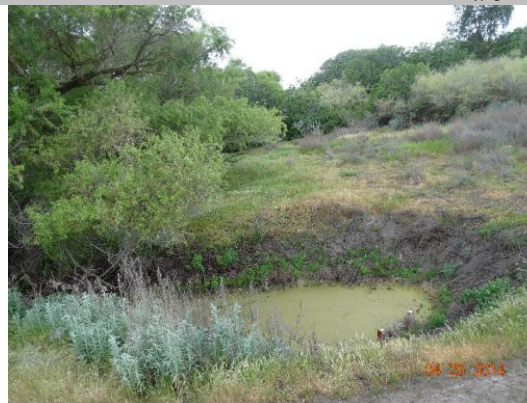
Photo 1 of 3 : UCIP\_SP\_2019\_39271\_66312.jpg

Comment Code					
Inspector Comment					
FS_ID:39271 DS_ID:19603 EP_NO: N/A Repair Type: Non-Urgent Crossing Status: Found UCIP Comments: 04/25/2014 Crossing is non-functional--crossing buried on landward side. Need to contact owner to determine status of crossing. If crossing is no longer used need to coordinate with CVFPB for proper abandonment. (DWR UCIP - O. Magana) FIELD_STRUCT_DESC: 36-inch corrugated metal gravity drainage pipe through the levee, 11.5 feet below the crown. Flap gate on the waterside (WS) end. Brass cap No. 40 bench mark (BM) on the headwall on the landside (LS). [Additional Reference(s): DWR Levee Log, 2002. USACE San Joaquin O&M Manual 601.1, 1967, (HLM 21.40)]. FS Date: 4/25/2014

View of waterward side.

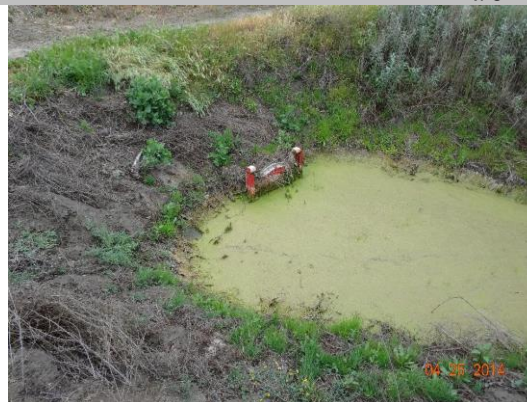
Photo 2 of 3 : UCIP\_SP\_2019\_39271\_66313.jpg

Flap gate half way submersed located on waterward side.

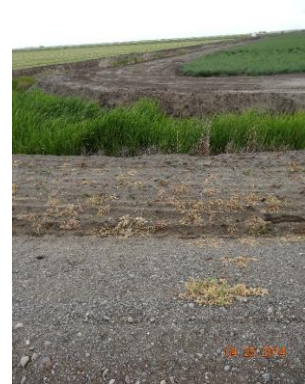
Photo 3 of 3 : UCIP\_SP\_2019\_39271\_66311.jpg

Comment Code					
Inspector Comment					
FS_ID:39271 DS_ID:19603 EP_NO: N/A Repair Type: Non-Urgent Crossing Status: Found UCIP Comments: 04/25/2014 Crossing is non-functional--crossing buried on landward side. Need to contact owner to determine status of crossing. If crossing is no longer used need to coordinate with CVFPB for proper abandonment. (DWR UCIP - O. Magana) FIELD_STRUCT_DESC: 36-inch corrugated metal gravity drainage pipe through the levee, 11.5 feet below the crown. Flap gate on the waterside (WS) end. Brass cap No. 40 bench mark (BM) on the headwall on the landside (LS). [Additional Reference(s): DWR Levee Log, 2002. USACE San Joaquin O&M Manual 601.1, 1967, (HLM 21.40)]. FS Date: 4/25/2014

View of landward side.

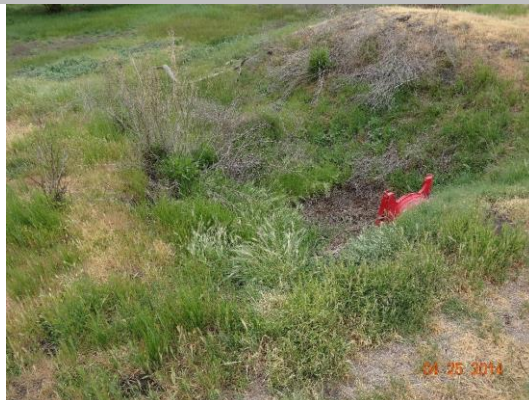
Photo 2 of 3 : UCIP\_SP\_2019\_39272\_65695.jpg

Flap gate visible on waterward side.

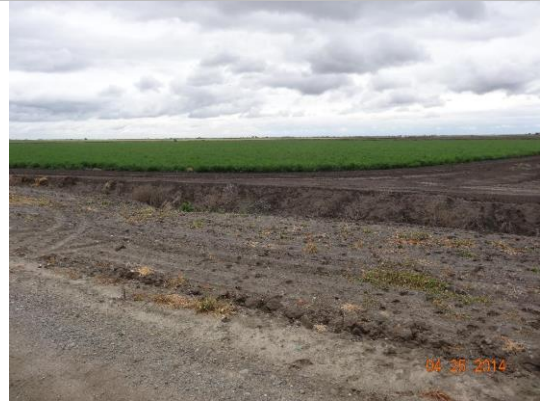
Photo 3 of 3 : UCIP\_SP\_2019\_39272\_65696.jpg

Item	DWR UCIP LMA Responsibility			37.176106°	37.176106°	
				-120.756768°	-120.756768°	
DWR ID	19604					
Comment Code						
Inspector Comment						
FS_ID:39272						
DS_ID:19604						
EP_NO: N/A						
Repair Type: Non-Urgent						
Crossing Status: Found						
UCIP Comments: 04/25/2014 Non-functional crossing-landward side is buried. Need to contact owner to determine status of crossing. If crossing is no longer used need to coordinate with CVFPB for proper abandonment. (DWR UCIP - O. Magana)						
FIELD_STRUCT_DESC: 24-inch corrugated metal gravity drainage pipe through the levee, 9 feet below the crown. Flap gate on the waterside (WS) end. Brass cap No. 40 bench mark (BM) on the headwall on the landside (LS). [Additional Reference(s): DWR Levee Log, 2002. USACE San Joaquin O&M Manual 601.1, 1967, (HLM 21.76)].						
FS Date: 4/25/2014

View of landward side.

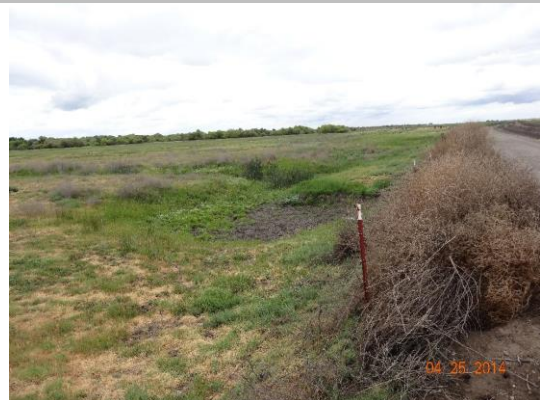
Photo 1 of 3 : UCIP\_SP\_2019\_39273\_65709.jpg

Comment Code						
Inspector Comment						
FS_ID:39273 DS_ID:19605 EP_NO: N/A Repair Type: Non-Urgent Crossing Status: Found UCIP Comments: 04/25/2014 Non-functional crossing--landward side is buried. Need to contact owner to determine status. If crossing is no longer used need to coordinate with CVFPB for proper abandonment. (DWR UCIP - O. Magana) FIELD_STRUCT_DESC: 24-inch corrugated metal gravity drainage pipe through the levee, 9 feet below the crown. Flap gate on the waterside (WS) end. Wooden headboards on the landside (LS) end. Brass cap No. 31 bench mark (BM) on the headwall on the LS. [Additional Reference(s): DWR Levee Log, 2002. USACE San Joaquin O&M Manual 601.1, 1967, (HLM 22.13)]. FS Date: 4/25/2014

View of waterward side.

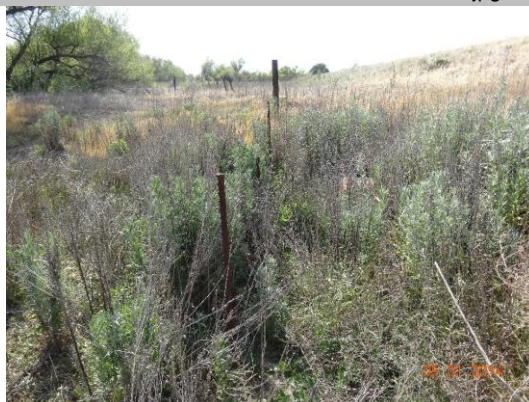
Photo 2 of 3 : UCIP\_SP\_2019\_36503\_66101.jpg

Fence along waterward side. No headwall was found on waterward side.

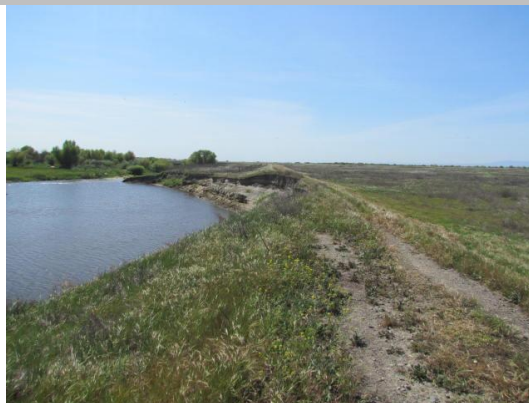
Photo 1 of 4 : SP\_2019\_NA0010\_119\_5\_20190307\_00005.jpg

LM Start	0.71	Rating **	U	Issue No.	5
LM End	0.78	Issue Type +	Ma	Location *	WS
Category	Earthen Levee			GPS Latitude/Longitude	
				Start	End
Item	Erosion / Bank Caving			37.287517 °	37.286543 °
				-120.874583 °	-120.873935 °
DWR ID	DWR_NA0010_02A_s_2012_5				
Comment Code					
E2 : Schedule repair of erosion site prior to the next inspection.					
Inspector Comment					
This levee unit is in the process of being turned over to State Parks.

Looking south at large erosion on waterside slope. (Spring 2012)

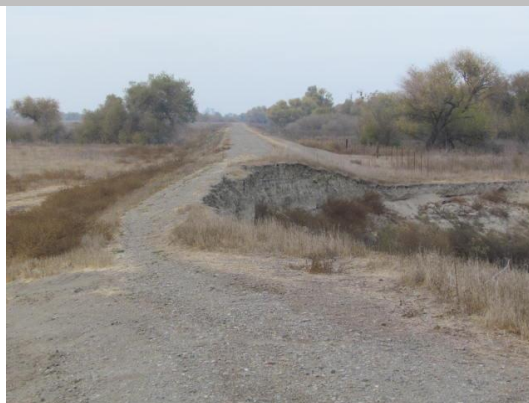
Photo 2 of 4 : SP\_2019\_NA0010\_119\_5\_20190307\_00006.jpg

Looking north at large erosion on waterward slope. (Fall 2013)

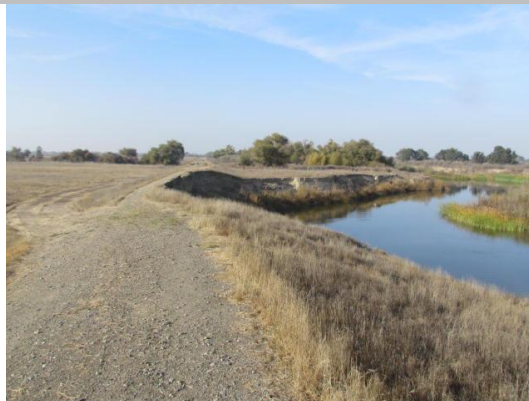
Photo 3 of 4 : SP\_2019\_NA0010\_119\_5\_20190307\_00007.jpg

Looking north at erosion on waterward slope. (Fall 2014)

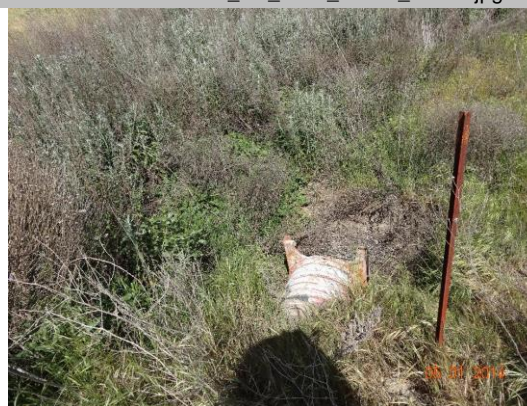
Photo 2 of 3 : UCIP\_SP\_2019\_39363\_66112.jpg

Comment Code						
Inspector Comment						
FS_ID:39363						
DS_ID:19654						
EP_NO: N/A						
Repair Type: Non-Urgent						
Crossing Status: Found						
UCIP Comments: 05/01/2014 Dense vegetation limits the inspector's visibility to identify signs of pipe failure (leaks) along the slope. Recommend removing vegetation along pipe alignment to conduct proper inspection of structure. Sediment buildup in pipe recommend clearing. (DWR UCIP - O. Magana)						
FIELD_STRUCT_DESC: 24-inch corrugated metal gravity drainage pipe through the levee, 8.6 feet below the crown. Flap gate on the waterside (WS) end. Brass cap No. 137 bench mark (BM) on the headwall on the landside (LS). [Additional Reference(s): DWR Levee Log, 2002. USACE San Joaquin O&M Manual 601.1, 1967, (HLM 1.02)].						
FS Date: 5/1/2014

Pipe visible on waterward side.

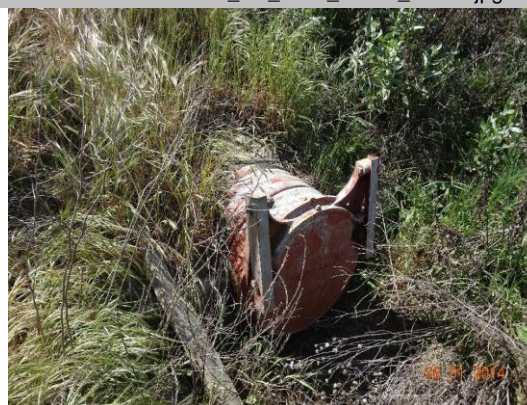
Photo 3 of 3 : UCIP\_SP\_2019\_39363\_66111.jpg

Flap gate visible on waterward side.

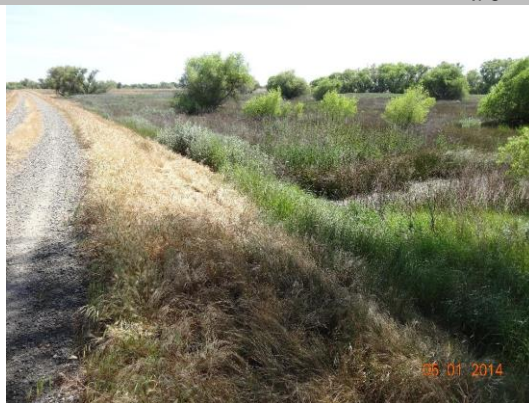
Photo 1 of 3 : UCIP\_SP\_2019\_36508\_66124.jpg

Comment Code					
Inspector Comment					
FS_ID:36508					
DS_ID:19657					
EP_NO: N/A					
Repair Type: Non-Urgent					
Crossing Status: Found					
UCIP Comments: 05/01/2014 Dense vegetation limits the inspector's visibility to identify signs of pipe failure (leaks) along the slope. Recommend removing vegetation along pipe alignment to conduct proper inspection of structure. (DWR UCIP - O. Magana)					
FIELD_STRUCT_DESC: 24-inch corrugated metal gravity drainage pipe through the levee, 10.2 feet below the crown. Flap gate on the waterside (WS) end. Brass cap No. 135 bench mark (BM) on the headwall on the landside (LS). [Additional Reference(s): DWR Levee Log, 2002. USACE San Joaquin O&M Manual 601.1, 1967, (HLM 1.62)].					
FS Date: 5/1/2014

Overview of landward side.

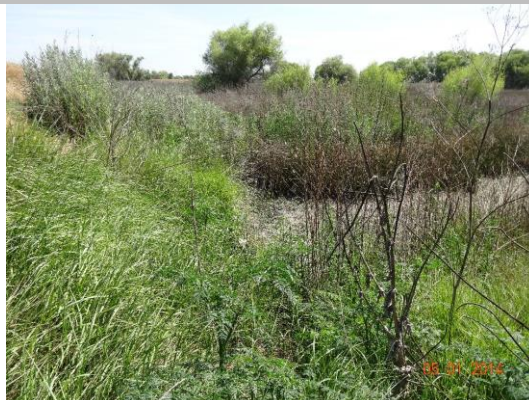
Photo 2 of 3 : UCIP\_SP\_2019\_36508\_66123.jpg

Dense vegetation along levee slope and toe.

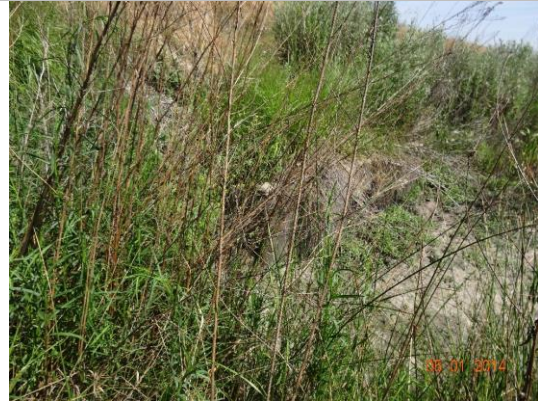
Photo 3 of 3 : UCIP\_SP\_2019\_36508\_66122.jpg

Comment Code						
Inspector Comment						
FS_ID:36508 DS_ID:19657 EP_NO: N/A Repair Type: Non-Urgent Crossing Status: Found UCIP Comments: 05/01/2014 Dense vegetation limits the inspector's visibility to identify signs of pipe failure (leaks) along the slope. Recommend removing vegetation along pipe alignment to conduct proper inspection of structure. (DWR UCIP - O. Magana) FIELD_STRUCT_DESC: 24-inch corrugated metal gravity drainage pipe through the levee, 10.2 feet below the crown. Flap gate on the waterside (WS) end. Brass cap No. 135 bench mark (BM) on the headwall on the landside (LS). [Additional Reference(s): DWR Levee Log, 2002. USACE San Joaquin O&M Manual 601.1, 1967, (HLM 1.62)]. FS Date: 5/1/2014

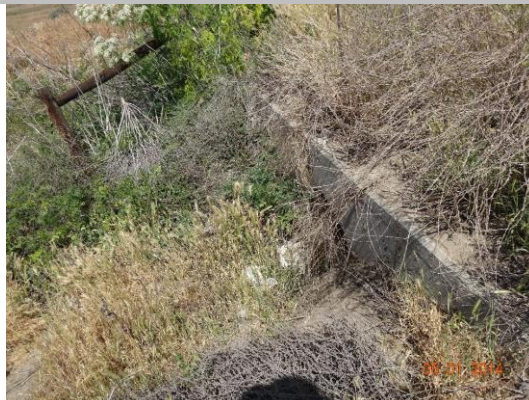
Photo 2 of 3 : UCIP\_SP\_2019\_36510\_66132.jpg

Comment Code						
Inspector Comment						
FS_ID:36510 DS_ID:19659 EP_NO: N/A Repair Type: Non-Urgent Crossing Status: Found UCIP Comments: 05/01/2014 Dense vegetation limits the inspector's visibility to identify signs of pipe failure (leaks) along the slope. Recommend removing vegetation along pipe alignment to conduct proper inspection of structure. (DWR UCIP - O. Magana) FIELD_STRUCT_DESC: 24-inch corrugated metal gravity drainage pipe through the levee, 7 feet below the crown. Flap gate on the waterside (WS) end. Brass cap No. 135 bench mark (BM) on the headwall on the landside (LS). [Additional Reference(s): DWR Levee Log, 2002. USACE San Joaquin O&M Manual 601.1, 1967, (HLM 2.30)]. FS Date: 5/1/2014

Concrete headwall visible on landward side.

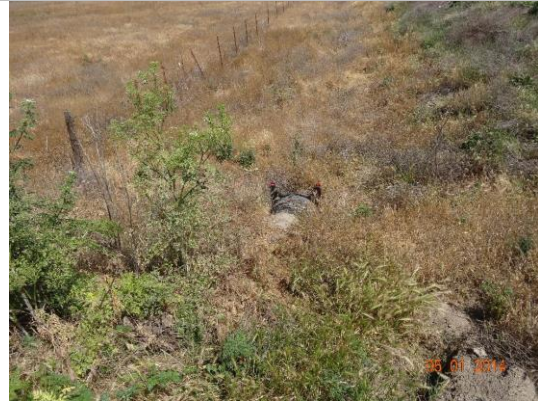
Photo 3 of 3 : UCIP\_SP\_2019\_36510\_66131.jpg

Comment Code						
Inspector Comment						
FS_ID:36510 DS_ID:19659 EP_NO: N/A Repair Type: Non-Urgent Crossing Status: Found UCIP Comments: 05/01/2014 Dense vegetation limits the inspector's visibility to identify signs of pipe failure (leaks) along the slope. Recommend removing vegetation along pipe alignment to conduct proper inspection of structure. (DWR UCIP - O. Magana) FIELD_STRUCT_DESC: 24-inch corrugated metal gravity drainage pipe through the levee, 7 feet below the crown. Flap gate on the waterside (WS) end. Brass cap No. 135 bench mark (BM) on the headwall on the landside (LS). [Additional Reference(s): DWR Levee Log, 2002. USACE San Joaquin O&M Manual 601.1, 1967, (HLM 2.30)]. FS Date: 5/1/2014

View of pipe through levee visible on waterward side.

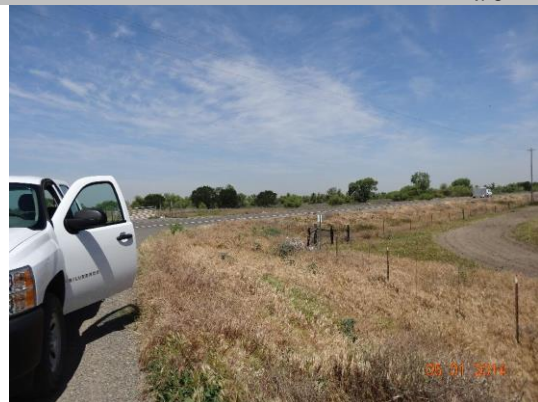
Photo 1 of 3 : UCIP\_SP\_2019\_36511\_66137.jpg

Comment Code					
Inspector Comment					
FS_ID:36511 DS_ID:19660 EP_NO: N/A Repair Type: Non-Urgent Crossing Status: Found UCIP Comments: 05/01/2014 Dense vegetation limits the inspector's visibility to identify signs of pipe failure (leaks) along the slope. Recommend removing vegetation along pipe alignment to conduct proper inspection of structure. (DWR UCIP - O. Magana) FIELD_STRUCT_DESC: 24-inch corrugated metal gravity drainage pipe through the levee, 7 feet below the crown. Flap gate on the waterside (WS) end. Brass cap No. 135 bench mark (BM) on the headwall on the landside (LS). [Additional Reference(s): DWR Levee Log, 2002. USACE San Joaquin O&M Manual 601.1, 1967, (HLM 2.32)]. FS Date: 5/1/2014

View of waterward side.

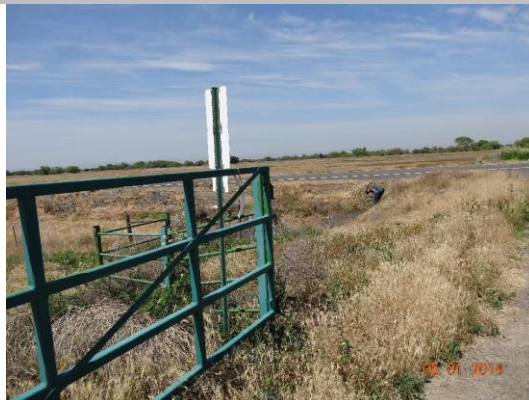
Photo 3 of 3 : UCIP\_SP\_2019\_36511\_66138.jpg

Comment Code						
Inspector Comment						
FS_ID:36511 DS_ID:19660 EP_NO: N/A Repair Type: Non-Urgent Crossing Status: Found UCIP Comments: 05/01/2014 Dense vegetation limits the inspector's visibility to identify signs of pipe failure (leaks) along the slope. Recommend removing vegetation along pipe alignment to conduct proper inspection of structure. (DWR UCIP - O. Magana) FIELD_STRUCT_DESC: 24-inch corrugated metal gravity drainage pipe through the levee, 7 feet below the crown. Flap gate on the waterside (WS) end. Brass cap No. 135 bench mark (BM) on the headwall on the landside (LS). [Additional Reference(s): DWR Levee Log, 2002. USACE San Joaquin O&M Manual 601.1, 1967, (HLM 2.32)]. FS Date: 5/1/2014

Overview of landward slope.

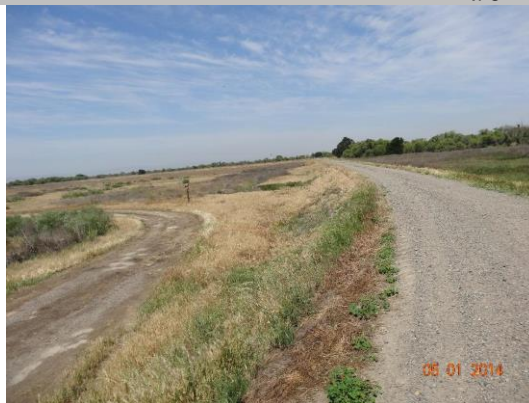
Photo 1 of 3 : UCIP\_SP\_2019\_36512\_66142.jpg

Comment Code						
Inspector Comment						
FS_ID:36512						
DS_ID:19661						
EP_NO: N/A						
Repair Type: Non-Urgent						
Crossing Status: Found						
UCIP Comments: 05/01/2014 Dense vegetation limits the inspector's						
visibility to identify signs of pipe failure (leaks) along the slope.						
Recommend removing vegetation along pipe alignment to conduct						
proper inspection of structure. (DWR UCIP - O. Magana)						
FIELD_STRUCT_DESC: 24-inch corrugated metal gravity drainage pipe						
through the levee, 10 feet below the crown. Flap gate on the waterside						
(WS) end. Brass cap No. 130 bench mark (BM) on the headwall on the						
landside (LS). [Additional Reference(s): DWR Levee Log, 2002. USACE						
San Joaquin O&M Manual 601.1, 1967, (HLM 2.59)].						
FS Date: 5/1/2014

View of landward side.

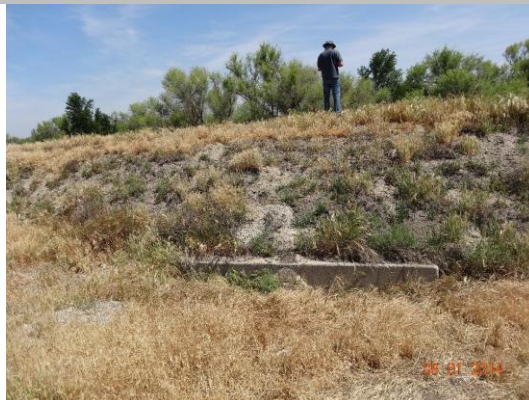
Photo 2 of 3 : UCIP\_SP\_2019\_36512\_66141.jpg

Concrete headwall visible on landward side.

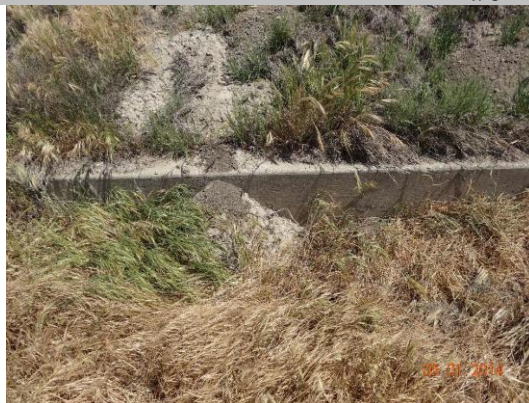
Photo 3 of 3 : UCIP\_SP\_2019\_36512\_66140.jpg

Comment Code						
Inspector Comment						
FS_ID:36512 DS_ID:19661 EP_NO: N/A Repair Type: Non-Urgent Crossing Status: Found UCIP Comments: 05/01/2014 Dense vegetation limits the inspector's visibility to identify signs of pipe failure (leaks) along the slope. Recommend removing vegetation along pipe alignment to conduct proper inspection of structure. (DWR UCIP - O. Magana) FIELD_STRUCT_DESC: 24-inch corrugated metal gravity drainage pipe through the levee, 10 feet below the crown. Flap gate on the waterside (WS) end. Brass cap No. 130 bench mark (BM) on the headwall on the landside (LS). [Additional Reference(s): DWR Levee Log, 2002. USACE San Joaquin O&M Manual 601.1, 1967, (HLM 2.59)]. FS Date: 5/1/2014

Non-functional crossing concrete headwall and inlet buried on landward side.

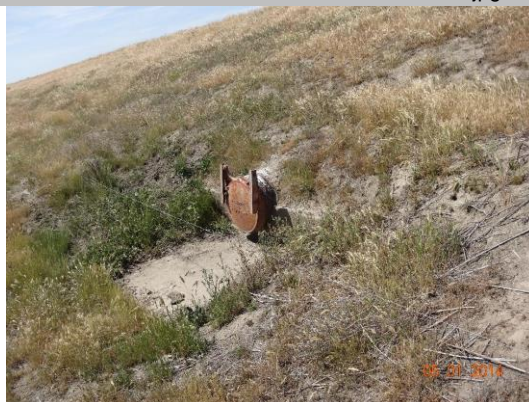
Photo 2 of 3 : UCIP\_SP\_2019\_36513\_66144.jpg

Comment Code					
Inspector Comment					
FS_ID:36513 DS_ID:19662 EP_NO: N/A Repair Type: Non-Urgent Crossing Status: Found UCIP Comments: 05/01/2014 Dense vegetation limits the inspector's visibility to identify signs of pipe failure (leaks) along the slope. Recommend removing vegetation along pipe alignment to conduct proper inspection of structure. (DWR UCIP - O. Magana) FIELD_STRUCT_DESC: 24-inch corrugated metal gravity drainage pipe through the levee, 10 feet below the crown. Flap gate on the waterside (WS) end. Brass cap No. 130 bench mark (BM) on the headwall on the landside (LS). [Additional Reference(s): DWR Levee Log, 2002. USACE San Joaquin O&M Manual 601.1, 1967, (HLM 2.96)]. FS Date: 5/1/2014

Flap gate visible on waterward side.

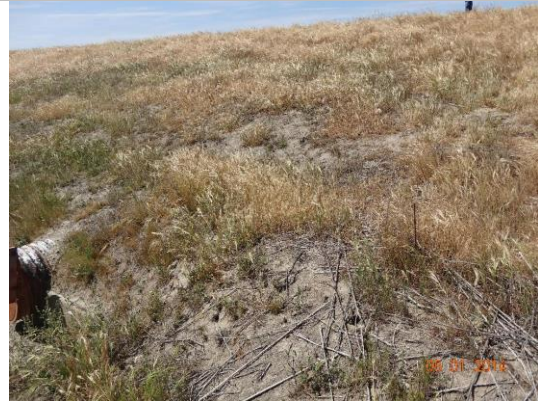
Photo 3 of 3 : UCIP\_SP\_2019\_36513\_66149.jpg

Comment Code						
Inspector Comment						
FS_ID:36513 DS_ID:19662 EP_NO: N/A Repair Type: Non-Urgent Crossing Status: Found UCIP Comments: 05/01/2014 Dense vegetation limits the inspector's visibility to identify signs of pipe failure (leaks) along the slope. Recommend removing vegetation along pipe alignment to conduct proper inspection of structure. (DWR UCIP - O. Magana) FIELD_STRUCT_DESC: 24-inch corrugated metal gravity drainage pipe through the levee, 10 feet below the crown. Flap gate on the waterside (WS) end. Brass cap No. 130 bench mark (BM) on the headwall on the landside (LS). [Additional Reference(s): DWR Levee Log, 2002. USACE San Joaquin O&M Manual 601.1, 1967, (HLM 2.96)]. FS Date: 5/1/2014

View of slope on waterward side.

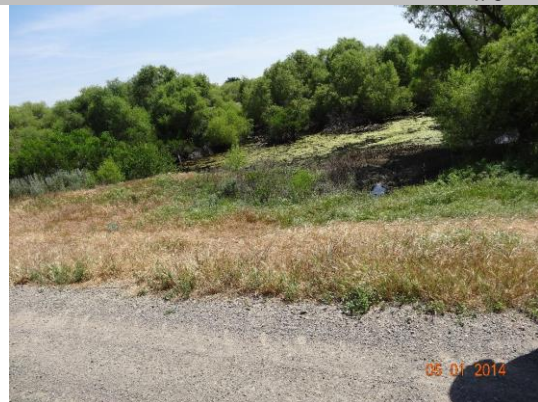
Photo 1 of 3 : UCIP\_SP\_2019\_36514\_66151.jpg

Comment Code						
Inspector Comment						
FS_ID:36514 DS_ID:19665 EP_NO: N/A Repair Type: Non-Urgent Crossing Status: Found UCIP Comments: 05/01/2014 Dense vegetation limits the inspector's visibility to identify signs of pipe failure (leaks) along the slope. Recommend removing vegetation along pipe alignment to conduct proper inspection of structure. (DWR UCIP - O. Magana) FIELD_STRUCT_DESC: 24-inch corrugated metal gravity drainage pipe through the levee, 12.4 feet below the crown. Flap gate on the waterside (WS) end. Brass cap No. 130 bench mark (BM) on the headwall on the landside (LS). [Additional Reference(s): DWR Levee Log, 2002. USACE San Joaquin O&M Manual 601.1, 1967, (HLM 3.29)]. FS Date: 5/1/2014

View of waterward side.

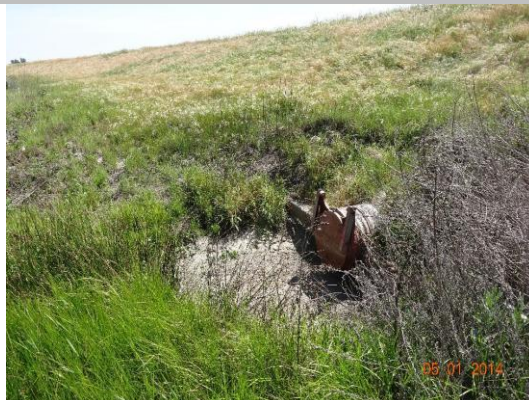
Photo 2 of 3 : UCIP\_SP\_2019\_36515\_66154.jpg

Flap gate visible on waterward side.

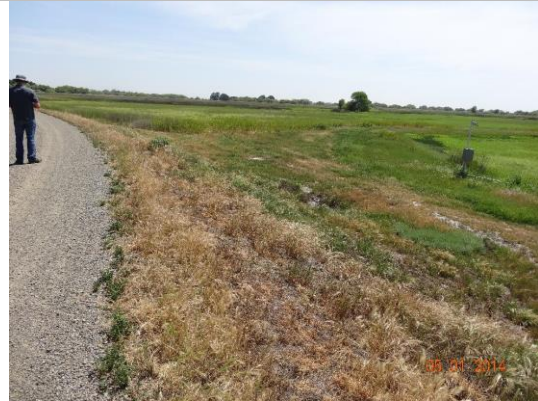
Photo 3 of 3 : UCIP\_SP\_2019\_36515\_66156.jpg

Comment Code						
Inspector Comment						
FS_ID:36515 DS_ID:19666 EP_NO: N/A Repair Type: Non-Urgent Crossing Status: Found UCIP Comments: 05/01/2014 Dense vegetation limits the inspector's visibility to identify signs of pipe failure (leaks) along the slope. Recommend removing vegetation along pipe alignment to conduct proper inspection of structure. (DWR UCIP - O. Magana) FIELD_STRUCT_DESC: 24-inch corrugated metal gravity drainage pipe through the levee, 10 feet below the crown. Flap gate on the waterside (WS) end. Brass cap No. 130 bench mark (BM) on the headwall on the landside (LS). [Additional Reference(s): DWR Levee Log, 2002. USACE San Joaquin O&M Manual 601.1, 1967, (HLM 3.62)]. FS Date: 5/1/2014

View of landward side.

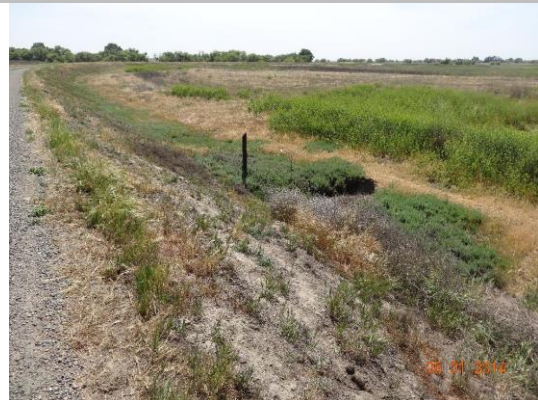
Photo 1 of 3 : UCIP\_SP\_2019\_39364\_66161.jpg

Comment Code						
Inspector Comment						
FS_ID:39364 DS_ID:19667 EP_NO: N/A Repair Type: Non-Urgent Crossing Status: Found UCIP Comments: 05/01/2014 Signs of erosion or sink hole present on landward toe--Need to contact owner. Dense vegetation limits the inspector's visibility to identify signs of pipe failure (leaks) along the slope. Recommend removing vegetation along pipe alignment to conduct proper inspection of structure. (DWR UCIP - O. Magana) FIELD_STRUCT_DESC: 24-inch corrugated metal gravity drainage pipe through the levee, 8.6 feet below the crown. Flap gate on the waterside (WS) end. Brass cap No. 130 bench mark (BM) on the headwall on the landside (LS). [Additional Reference(s): DWR Levee Log, 2002. USACE San Joaquin O&M Manual 601.1, 1967, (HLM 3.95)]. FS Date: 5/1/2014

View of landward side.
