**Flood Control Project Maintenance  
Levee Inspections**

## Maintenance Issue Types Only, Levee Inspection Report By Mile - Spring 2019

### Lower San Joaquin Levee District

Waterway	Bank	Unit Miles	Inspection Start/End	Inspector
Unit No. 01 San Joaquin River	Right	22.52	03/26/2019 03/26/2019	Corey Fujitani

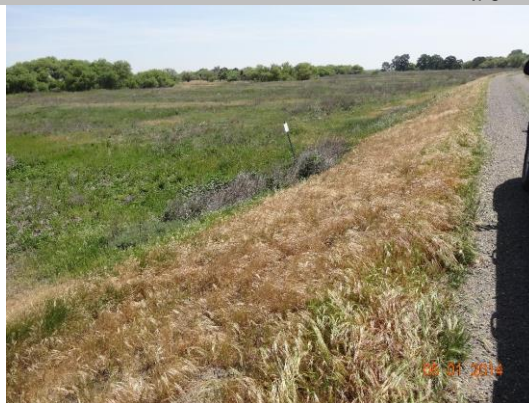
Photo 2 of 3 : UCIP\_SP\_2019\_39364\_66160.jpg

Comment Code						
Inspector Comment						
FS_ID:39364						
DS_ID:19667						
EP_NO: N/A						
Repair Type: Non-Urgent						
Crossing Status: Found						
UCIP Comments: 05/01/2014 Signs of erosion or sink hole present on landward toe--Need to contact owner. Dense vegetation limits the inspector's visibility to identify signs of pipe failure (leaks) along the slope. Recommend removing vegetation along pipe alignment to conduct proper inspection of structure. (DWR UCIP - O. Magana)						
FIELD_STRUCT_DESC: 24-inch corrugated metal gravity drainage pipe through the levee, 8.6 feet below the crown. Flap gate on the waterside (WS) end. Brass cap No. 130 bench mark (BM) on the headwall on the landside (LS). [Additional Reference(s): DWR Levee Log, 2002. USACE San Joaquin O&M Manual 601.1, 1967, (HLM 3.95)].						
FS Date: 5/1/2014

View of waterward side.

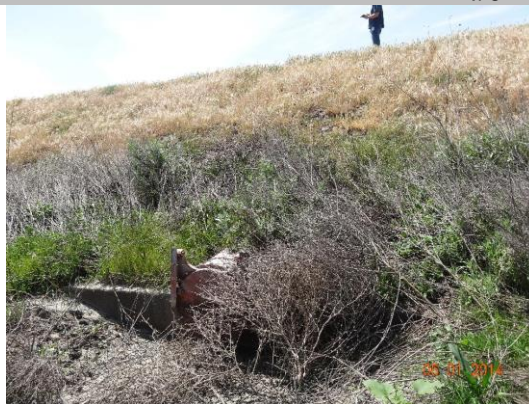
Photo 3 of 3 : UCIP\_SP\_2019\_39364\_66159.jpg

Flap gate and concrete headwall visible through dense vegetation.

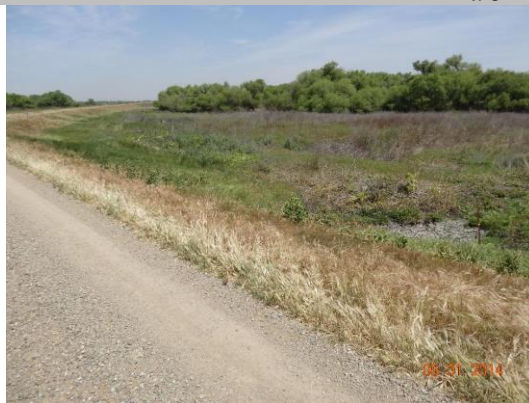
Photo 1 of 3 : UCIP\_SP\_2019\_36517\_66167.jpg

Comment Code					
Inspector Comment					
FS_ID:36517 DS_ID:19668 EP_NO: N/A Repair Type: Non-Urgent Crossing Status: Found UCIP Comments: 05/01/2014 Dense vegetation limits the inspector's visibility to identify signs of pipe failure (leaks) along the slope. Recommend removing vegetation along pipe alignment to conduct proper inspection of structure. (DWR UCIP - O. Magana) FIELD_STRUCT_DESC: 24-inch corrugated metal gravity drainage pipe through the levee, 8 feet below the crown. Flap gate on the waterside (WS) end. Brass cap No. 125 bench mark (BM) on the headwall on the landside (LS). [Additional Reference(s): DWR Levee Log, 2002. USACE San Joaquin O&M Manual 601.1, 1967, (HLM 5.43)]. FS Date: 5/1/2014

View of waterward side.

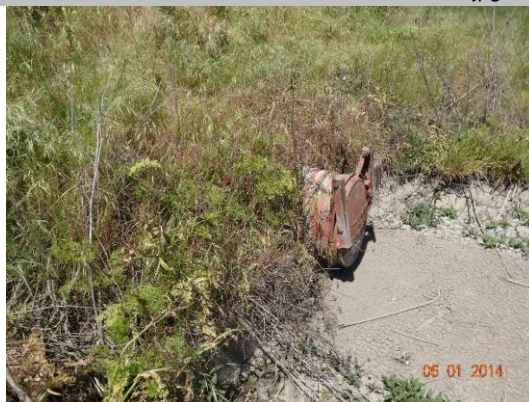
Photo 2 of 3 : UCIP\_SP\_2019\_36517\_66166.jpg

Flap gate visible on waterward side.

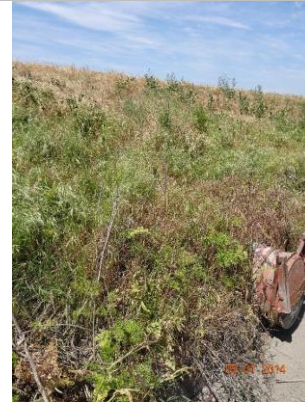
Photo 3 of 3 : UCIP\_SP\_2019\_36517\_66165.jpg

Comment Code						
Inspector Comment						
FS_ID:36517 DS_ID:19668 EP_NO: N/A Repair Type: Non-Urgent Crossing Status: Found UCIP Comments: 05/01/2014 Dense vegetation limits the inspector's visibility to identify signs of pipe failure (leaks) along the slope. Recommend removing vegetation along pipe alignment to conduct proper inspection of structure. (DWR UCIP - O. Magana) FIELD_STRUCT_DESC: 24-inch corrugated metal gravity drainage pipe through the levee, 8 feet below the crown. Flap gate on the waterside (WS) end. Brass cap No. 125 bench mark (BM) on the headwall on the landside (LS). [Additional Reference(s): DWR Levee Log, 2002. USACE San Joaquin O&M Manual 601.1, 1967, (HLM 5.43)]. FS Date: 5/1/2014

View of waterward slope covered by vegetation.

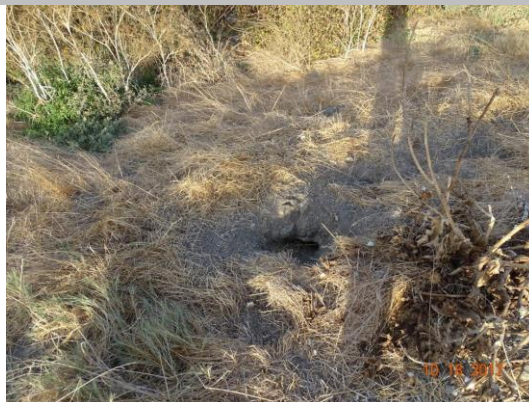
Photo 1 of 1 : SP\_2019\_NA0010\_119\_28\_20190307\_00015.jpg

LM Start	6.97	Rating **	M	Issue No.	28
LM End	6.97	Issue Type +	Ma	Location *	LS
Category	Earthen Levee			GPS Latitude/Longitude	
				Start	End
Item	Animal Control			37.241125 °	37.241125 °
				-120.821747 °	-120.821747 °
DWR ID	DWR_NA0010_02A_f_2017_28				
Comment Code					
A3 : No rodents visible, but rodent burrows visible; need to backfill and compact or grout burrows.					
Inspector Comment

Looking northwest at landside slope.

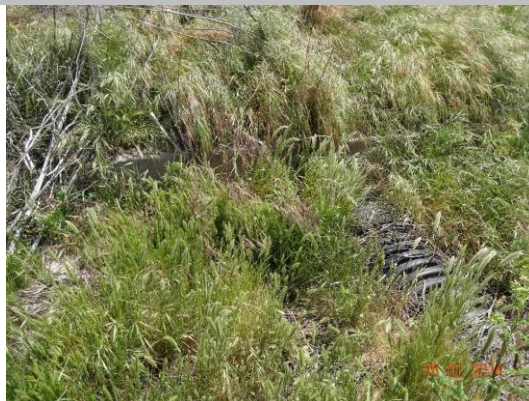
Photo 2 of 3 : UCIP\_SP\_2019\_39365\_66177.jpg

Pipe extension visible on landward side attached to inlet at concrete headwall.

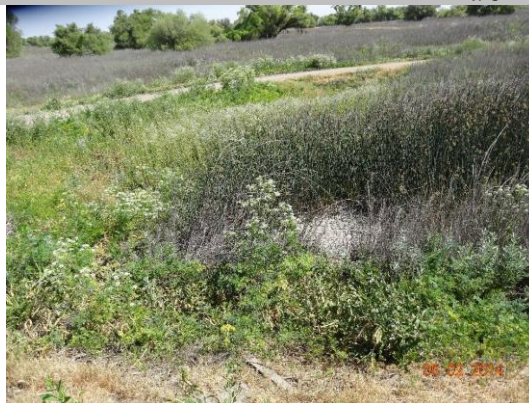
Photo 1 of 3 : UCIP\_SP\_2019\_36521\_66183.jpg

Comment Code						
Inspector Comment						
FS_ID:36521 DS_ID:19673 EP_NO: N/A Repair Type: Non-Urgent Crossing Status: Found UCIP Comments: 05/01/2014 Dense vegetation limits the inspector's visibility to identify signs of pipe failure (leaks) along the slope. Recommend removing vegetation along pipe alignment to conduct proper inspection of structure. (DWR UCIP - O. Magana) FIELD_STRUCT_DESC: 24-inch corrugated metal gravity drainage pipe through the levee, 8 feet below the crown. Flap gate on the waterside (WS) end. Brass cap No. 125 bench mark (BM) on the headwall on the landside (LS). [Additional Reference(s): DWR Levee Log, 2002. USACE San Joaquin O&M Manual 601.1, 1967, (HLM 7.77)]. FS Date: 5/1/2014

View of waterward side.

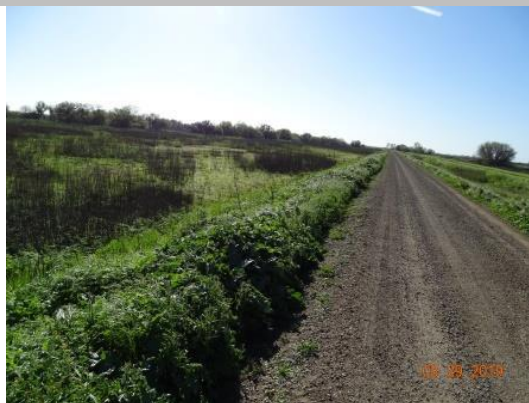
Photo 1 of 1 : SP\_2019\_NA0010\_120\_23\_20190415\_00051.jpg

LM Start	7.87	Rating **	U	Issue No.	23
LM End	13.72	Issue Type +	Ma	Location *	WS
Category	Earthen Levee			GPS Latitude/Longitude	
				Start	End
Item	Vegetation			37.231266 °	37.172587 °
				-120.811850 °	-120.761157 °
DWR ID	DWR_NA0010_02B_s_2019_23				
Comment Code					
V1 : Control annual grass and weeds on the levee slopes and easements.					
Inspector Comment

View of waterside slope looking upstream. (Spring 2019)

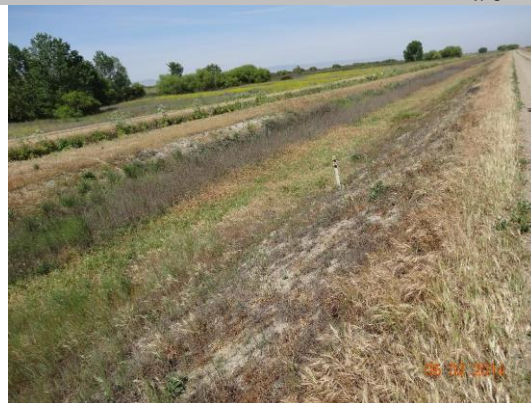
Photo 1 of 3 : UCIP\_SP\_2019\_39367\_66195.jpg

Comment Code						
Inspector Comment						
FS_ID:39367						
DS_ID:19675						
EP_NO: N/A						
Repair Type: Non-Urgent						
Crossing Status: Found						
UCIP Comments: 05/14/2014 Dense vegetation on landward toe. Also dense vegetation limits the inspector's visibility to identify signs of pipe failure (leaks) along waterward slope. Recommend removing vegetation along pipe alignment toe to conduct proper inspection of structure. Sediment buildup in pipe--recommend clearing. (DWR UCIP - O. Magana)						
FIELD_STRUCT_DESC: 24-inch corrugated metal gravity drainage pipe through the levee, 9.4 feet below the crown. Flap gate on the waterside (WS) end. Brass cap No. 120 bench mark (BM) on the headwall on the landside (LS). [Additional Reference(s): DWR Levee Log, 2002. USACE San Joaquin O&M Manual 601.1, 1967, (HLM 8.48)].						
FS Date: 5/14/2014

View of landward side.

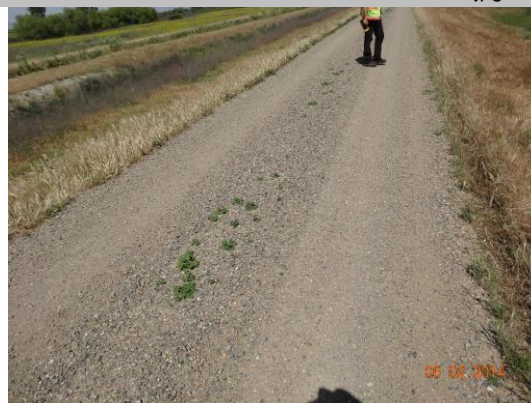
Photo 2 of 3 : UCIP\_SP\_2019\_39367\_66193.jpg

Overview of levee crown at crossing.

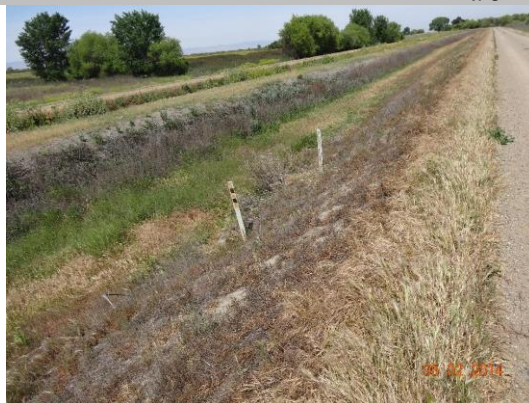
Photo 1 of 3 : UCIP\_SP\_2019\_42503\_66200.jpg

Comment Code					
Inspector Comment					
FS_ID:42503 DS_ID:19676 EP_NO: N/A Repair Type: Non-Urgent Crossing Status: Found UCIP Comments: 05/14/2014 Dense vegetation limits the inspector's visibility to identify signs of pipe failure (leaks) along the slope. Recommend removing vegetation along pipe alignment to conduct proper inspection of structure. Burrow activity presen on waterward slope. (DWR UCIP - O. Magana) FIELD_STRUCT_DESC: 24-inch corrugated metal gravity drainage pipe through the levee, 8.8 feet below the crown. Flap gate on the waterside (WS) end. Brass cap No. 120 bench mark (BM) on the headwall on the landside (LS). [Additional Reference(s): DWR Levee Log, 2002. USACE San Joaquin O&M Manual 601.1, 1967, (recorded as HLM 9.86 should be 8.86)]. FS Date: 5/14/2014

View of landward side.

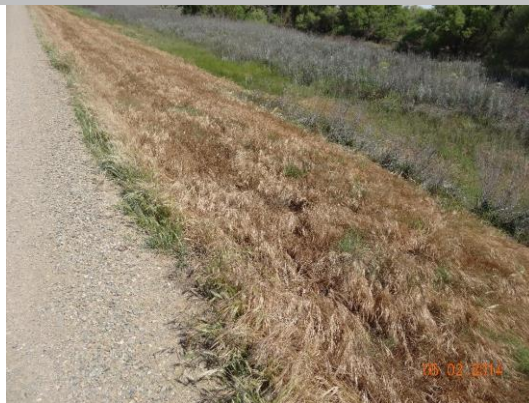
Photo 2 of 3 : UCIP\_SP\_2019\_42503\_66199.jpg

View of waterward side.

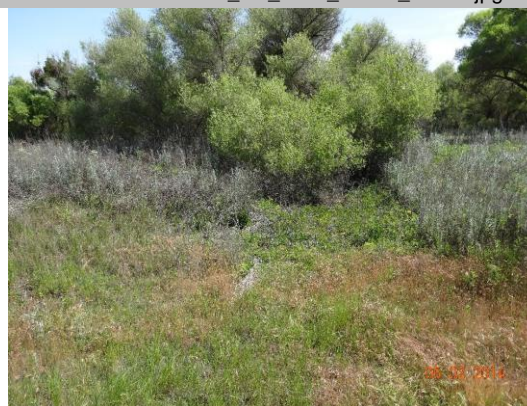
Photo 3 of 3 : UCIP\_SP\_2019\_42503\_66201.jpg

Comment Code						
Inspector Comment						
FS_ID:42503 DS_ID:19676 EP_NO: N/A Repair Type: Non-Urgent Crossing Status: Found UCIP Comments: 05/14/2014 Dense vegetation limits the inspector's visibility to identify signs of pipe failure (leaks) along the slope. Recommend removing vegetation along pipe alignment to conduct proper inspection of structure. Burrow activity presen on waterward slope. (DWR UCIP - O. Magana) FIELD_STRUCT_DESC: 24-inch corrugated metal gravity drainage pipe through the levee, 8.8 feet below the crown. Flap gate on the waterside (WS) end. Brass cap No. 120 bench mark (BM) on the headwall on the landside (LS). [Additional Reference(s): DWR Levee Log, 2002. USACE San Joaquin O&M Manual 601.1, 1967, (recorded as HLM 9.86 should be 8.86)]. FS Date: 5/14/2014

View of waterward toe.

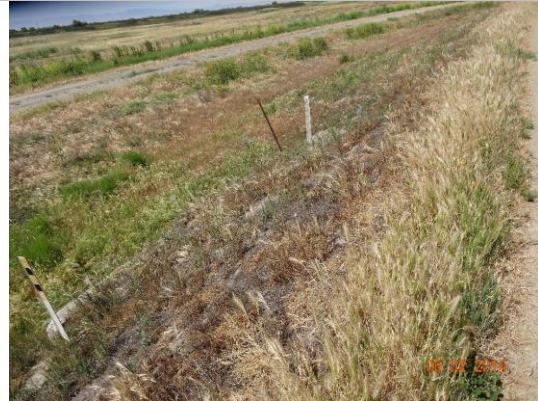
Photo 3 of 3 : UCIP\_SP\_2019\_36525\_66206.jpg

Comment Code						
Inspector Comment						
FS_ID:36525 DS_ID:19677 EP_NO: N/A Repair Type: Non-Urgent Crossing Status: Found UCIP Comments: 05/14/2014 Dense vegetation limits the inspector's visibility to identify signs of pipe failure (leaks) along the slope. Recommend removing vegetation along pipe alignment to conduct proper inspection of structure. (DWR UCIP - O. Magana) FIELD_STRUCT_DESC: 36-inch corrugated metal gravity drainage pipe through the levee, 8.8 feet below the crown. Flap gate on the waterside (WS) end. Brass cap No. 120 bench mark (BM) on the headwall on the landside (LS). [Additional Reference(s): DWR Levee Log, 2002. USACE San Joaquin O&M Manual 601.1, 1967, (HLM 9.02)]. FS Date: 5/14/2014

View of landward side.

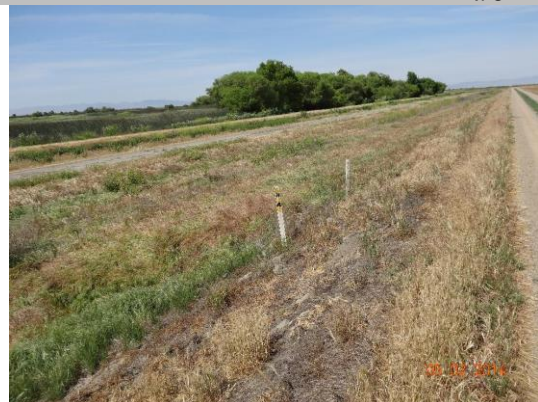
Photo 1 of 3 : UCIP\_SP\_2019\_40443\_66211.jpg

Comment Code						
Inspector Comment						
FS_ID:40443 DS_ID:19678 EP_NO: N/A Repair Type: Non-Urgent Crossing Status: Found UCIP Comments: 05/14/2014 Dense vegetation limits the inspector's visibility to identify signs of pipe failure (leaks) along the slope. Recommend removing vegetation along pipe alignment to conduct proper inspection of structure. (DWR UCIP - O. Magana) FIELD_STRUCT_DESC: 24-inch corrugated metal gravity drainage pipe through the levee, 8 feet below the crown. Flap gate on the waterside (WS) end. Brass cap No. 120 bench mark (BM) on the headwall on the landside (LS). [Additional Reference(s): DWR Levee Log, 2002. USACE San Joaquin O&M Manual 601.1, 1967, (HLM 9.20)]. FS Date: 5/14/2014

View of landward side.

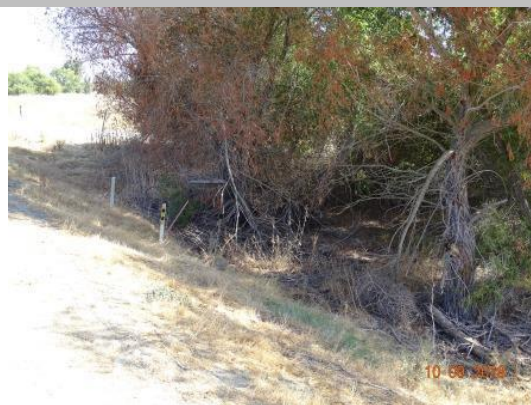
Photo 2 of 2 : SP\_2019\_NA0010\_120\_17\_20190307\_00007.jpg

LM Start	9.42	Rating **	M	Issue No.	17
LM End	9.42	Issue Type +	Ma	Location *	LS
Category	Earthen Levee			GPS Latitude/Longitude	
				Start	End
Item	Trim / Thin Trees			37.220199°	37.220199°
				-120.788748°	-120.788748°
DWR ID	DWR_NA0010_02B_f_2016_17				
Comment Code					
T3 : Trim and thin trees to allow visibility of the ground and room to flood fight.					
Inspector Comment					
Trim back dead tree limbs on landside toe.

View of dead branches on landside toe. (Fall 2018)

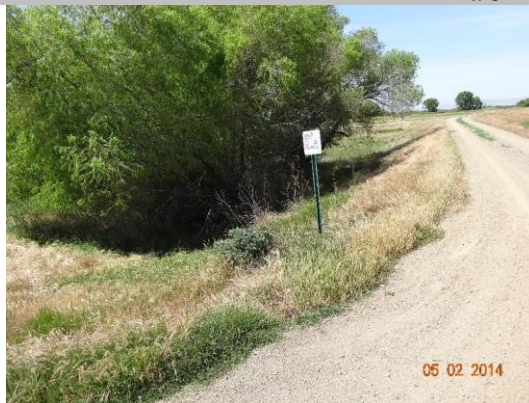
Photo 1 of 3 : UCIP\_SP\_2019\_36527\_66217.jpg

Comment Code						
Inspector Comment						
FS_ID:36527 DS_ID:19686 EP_NO: N/A Repair Type: Non-Urgent Crossing Status: Found UCIP Comments: 05/14/2014 Dense vegetation limits the inspector's visibility to identify signs of pipe failure (leaks) along the slope. Recommend removing vegetation along pipe alignment to conduct proper inspection of structure. (DWR UCIP - O. Magana) FIELD_STRUCT_DESC: 24-inch corrugated metal gravity drainage pipe through the levee, 9 feet below the crown. Flap gate on the waterside (WS) end. Brass cap No. 115 bench mark (BM) on the headwall on the landside (LS). [Additional Reference(s): DWR Levee Log, 2002. USACE San Joaquin O&M Manual 601.1, 1967, (HLM 9.46)]. FS Date: 5/14/2014

View of landward side.

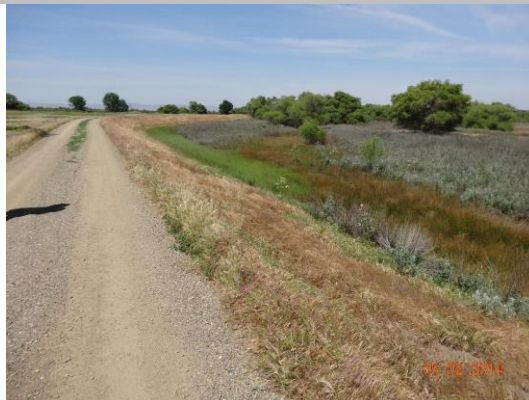
Photo 2 of 3 : UCIP\_SP\_2019\_36527\_66216.jpg

LM Start	<b>9.43</b>	Rating **	M	Issue No.	<b>31 (cont)</b>
LM End	<b>9.43</b>	Issue Type +	Ma	Location *

View of waterward side.

Comment Code						
Inspector Comment						
FS_ID:36527						
DS_ID:19686						
EP_NO: N/A						
Repair Type: Non-Urgent						
Crossing Status: Found						
UCIP Comments: 05/14/2014 Dense vegetation limits the inspector's visibility to identify signs of pipe failure (leaks) along the slope. Recommend removing vegetation along pipe alignment to conduct proper inspection of structure. (DWR UCIP - O. Magana)						
FIELD_STRUCT_DESC: 24-inch corrugated metal gravity drainage pipe through the levee, 9 feet below the crown. Flap gate on the waterside (WS) end. Brass cap No. 115 bench mark (BM) on the headwall on the landside (LS). [Additional Reference(s): DWR Levee Log, 2002. USACE San Joaquin O&M Manual 601.1, 1967, (HLM 9.46)].						
FS Date: 5/14/2014

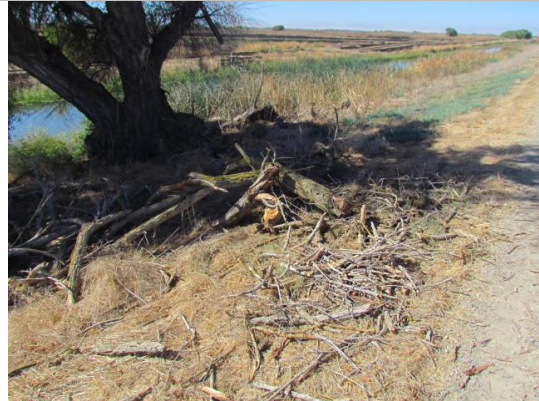
Photo 2 of 2 : SP\_2019\_NA0010\_120\_14\_20190307\_00005.jpg

LM Start	10.94	Rating **	M	Issue No.	14 (cont)	
LM End	10.94	Issue Type +	Ma	Location *	LS	
Category	Earthen Levee			GPS Latitude/Longitude		
				Start		End
Item	Encroachments			37.205711 °		37.205711 °
				-120.774741 °		-120.774741 °
DWR ID	DWR_NA0010_02B_f_2015_14					
Comment Code						
PR : Prunings						
Inspector Comment						
Remove prunings from landside toe.

Looking at prunings on landward slope. (Spring 2018)

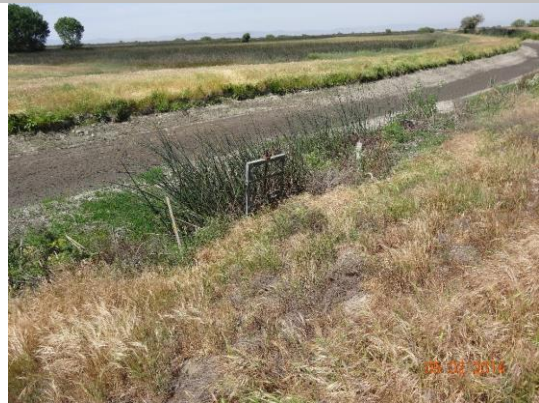
Photo 1 of 3 : UCIP\_SP\_2019\_36530\_66236.jpg

LM Start	11.14	Rating **	M	Issue No.	34	
LM End	11.14	Issue Type +	Ma	Location *		
Category	Supplemental			GPS Latitude/Longitude		
				Start	End	
Item	DWR UCIP LMA Responsibility			37.204640 °	37.204640 °	
				-120.771564 °	-120.771564 °	
DWR ID	19689

View of landward slope.

Comment Code						
Inspector Comment						
FS_ID:36530						
DS_ID:19689						
EP_NO: N/A						
Repair Type: Non-Urgent						
Crossing Status: Found						
UCIP Comments: 05/14/2014 Dense vegetation limits the inspector's visibility to identify signs of pipe failure (leaks) along the slope. Recommend removing vegetation along pipe alignment to conduct proper inspection of structure. (DWR UCIP - O. Magana)						
FIELD_STRUCT_DESC: 24-inch corrugated metal gravity drainage pipe through the levee, 8 feet below the crown. Flap gate on the waterside (WS) end. Brass cap No. 115 bench mark (BM) on the headwall on the landside (LS). [Additional Reference(s): DWR Levee Log, 2002. USACE San Joaquin O&M Manual 601.1, 1967, (HLM 11.17)].						
FS Date: 5/14/2014

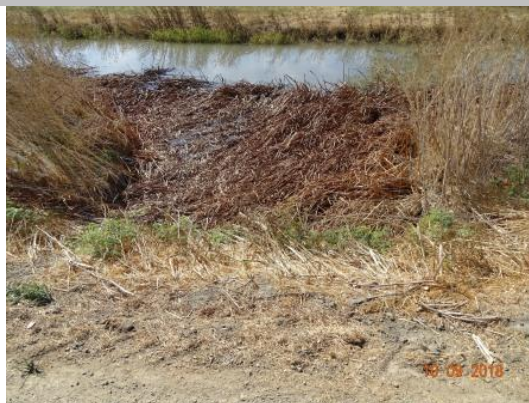
Photo 2 of 2 : SP\_2019\_NA0010\_120\_21\_20190307\_00012.jpg

LM Start	<b>11.39</b>	Rating **	U	Issue No.	<b>21 (cont)</b>
LM End	<b>11.39</b>	Issue Type +	Ma	Location *	LS

View of erosion site looking down landside slope. (Fall 2018)

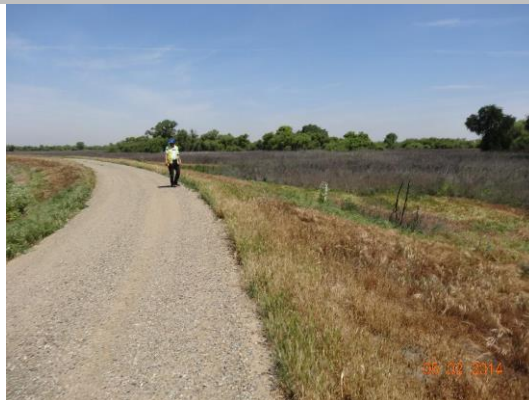
Photo 2 of 3 : UCIP\_SP\_2019\_36531\_66240.jpg

View of waterward side.

Comment Code						
Inspector Comment						
FS_ID:36531 DS_ID:19690 EP_NO: N/A Repair Type: Non-Urgent Crossing Status: Found UCIP Comments: 05/14/2014 Dense vegetation limits the inspector's visibility to identify signs of pipe failure (leaks) along the slope. Recommend removing vegetation along pipe alignment to conduct proper inspection of structure. (DWR UCIP - O. Magana) FIELD_STRUCT_DESC: 24-inch corrugated metal gravity drainage pipe through the levee, 8 feet below the crown. Flap gate on the waterside (WS) end. Screw gate on the landside (LS). [Additional Reference(s): DWR Levee Log, 2002. USACE San Joaquin O&M Manual 601.1, 1967, (HLM 11.43)]. FS Date: 5/14/2014

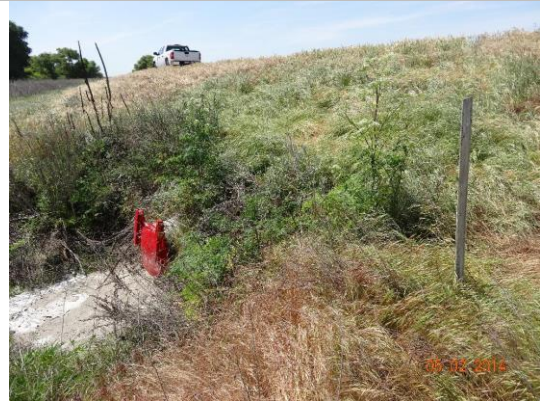
Photo 3 of 3 : UCIP\_SP\_2019\_36531\_66239.jpg

Flap gate visible on waterward toe.

Comment Code						
Inspector Comment						
FS_ID:36531 DS_ID:19690 EP_NO: N/A Repair Type: Non-Urgent Crossing Status: Found UCIP Comments: 05/14/2014 Dense vegetation limits the inspector's visibility to identify signs of pipe failure (leaks) along the slope. Recommend removing vegetation along pipe alignment to conduct proper inspection of structure. (DWR UCIP - O. Magana) FIELD_STRUCT_DESC: 24-inch corrugated metal gravity drainage pipe through the levee, 8 feet below the crown. Flap gate on the waterside (WS) end. Screw gate on the landside (LS). [Additional Reference(s): DWR Levee Log, 2002. USACE San Joaquin O&M Manual 601.1, 1967, (HLM 11.43)]. FS Date: 5/14/2014

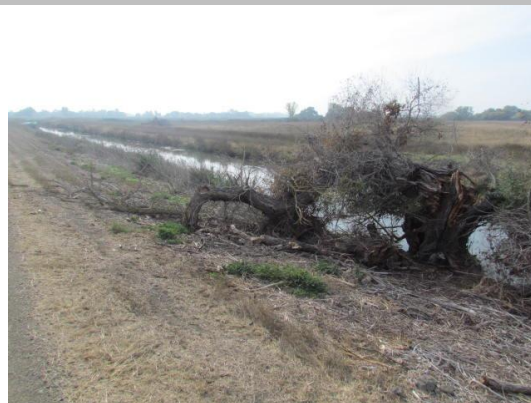
Photo 2 of 2 : SP\_2019\_NA0010\_120\_1\_20190307\_00002.jpg

LM Start	12.21	Rating **	M	Issue No.	1 (cont)	
LM End	12.21	Issue Type +	Ma	Location *	LS	
Category	Earthen Levee			GPS Latitude/Longitude		
				Start		End
Item	Encroachments			37.191528 °	37.191528 °	
				-120.764541 °	-120.764541 °	
DWR ID	DWR_NA0010_02B_f_2014_1					
Comment Code						
TR : Tree or limb						
Inspector Comment						
Fallen tree limbs are located on the landside slope.

Looking southwest at tree limb on landward slope.

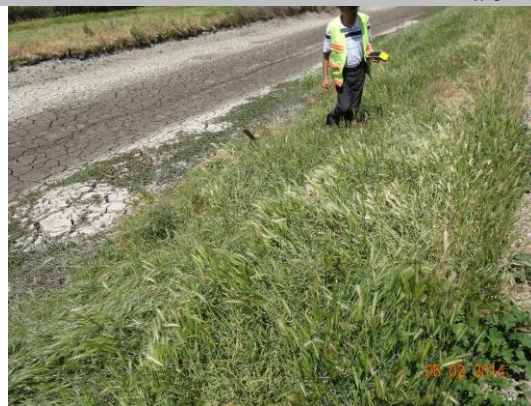
Photo 1 of 3 : UCIP\_SP\_2019\_39370\_66245.jpg

LM Start	13.18	Rating **	M	Issue No.	36
LM End	13.18	Issue Type +	Ma	Location *	
Category	Supplemental			GPS Latitude/Longitude	
				Start	End
Item	DWR UCIP LMA Responsibility			37.179265 °	37.179265 °
				-120.764870 °	-120.764870 °
DWR ID	19663

View of landward side.

Comment Code					
Inspector Comment					
FS_ID:39370 DS_ID:19663 EP_NO: N/A Repair Type: Non-Urgent Crossing Status: Found UCIP Comments: 05/14/2014 Dense vegetation limits the inspector's visibility to identify signs of pipe failure (leaks) along the slope. Recommend removing vegetation along pipe alignment to conduct proper inspection of structure. Sediment buildup in pipe--recommend clearing. (DWR UCIP - O. Magana) FIELD_STRUCT_DESC: 24-inch corrugated metal gravity drainage pipe through the levee, 6.5 feet below the crown. Slide gate in a pipe riser on the waterside (WS) slope. [Additional Reference(s): DWR Levee Log, 2002. USACE San Joaquin O&M Manual 601.1, 1967, (recorded as HLM 13.32 should be 13.22)]. FS Date: 5/14/2014

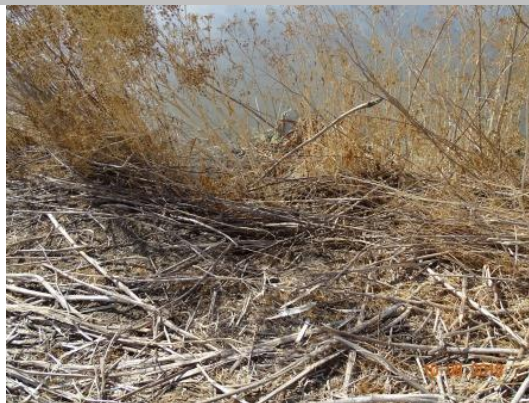
Photo 1 of 2 : SP\_2019\_NA0010\_120\_25\_20190307\_00015.jpg

LM Start	13.72	Rating **	M	Issue No.	25
LM End	13.72	Issue Type +	Ma	Location *	LS
Category	Earthen Levee			GPS Latitude/Longitude	
				Start	End
Item	Erosion / Bank Caving			37.172648 °	37.172648 °
				-120.761157 °	-120.761157 °
DWR ID	DWR_NA0010_02B_f_2018_25				
Comment Code					
E1 : Note and monitor erosion site.					
Inspector Comment					
Erosion is occurring into the landside bank.

Looking down landside slope from crown at erosion site. (Fall 2018)

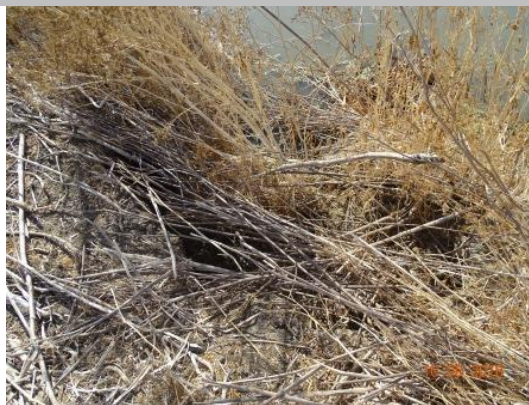
Photo 2 of 2 : SP\_2019\_NA0010\_120\_25\_20190307\_00016.jpg

LM Start	<b>13.72</b>	Rating **	M	Issue No.	<b>25 (cont)</b>
LM End	<b>13.72</b>	Issue Type +	Ma	Location *	LS

View of erosion on landside slope. (Fall 2018)

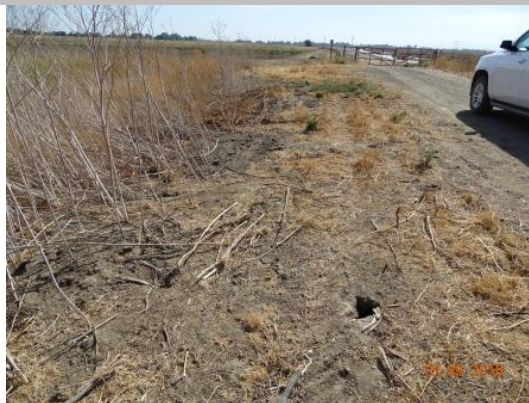
Photo 1 of 2 : SP\_2019\_NA0010\_120\_22\_20190307\_00013.jpg

LM Start	13.73	Rating **	M	Issue No.	22
LM End	13.73	Issue Type +	Ma	Location *	WS
Category	Earthen Levee			GPS Latitude/Longitude	
				Start	End
Item	Animal Control			37.172387 °	37.172387 °
				-120.761190 °	-120.761190 °
DWR ID	DWR_NA0010_02B_f_2018_22				
Comment Code					
A1 : Exterminate rodents and backfill and compact or grout burrows.					
Inspector Comment					
There are several rodent burrows observed at this location

View of waterside slope looking upstream. (Fall 2018)

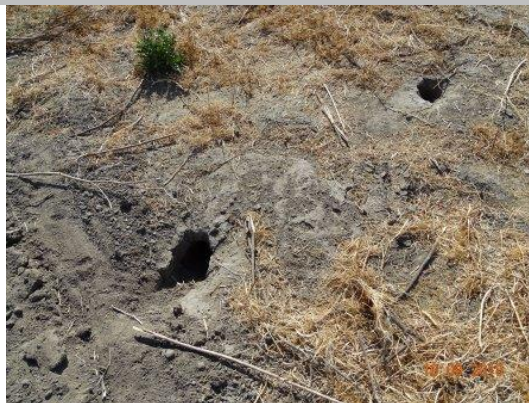
Photo 2 of 2 : SP\_2019\_NA0010\_120\_22\_20190307\_00014.jpg

LM Start	13.73	Rating **	M	Issue No.	22 (cont)	
LM End	13.73	Issue Type +	Ma	Location *	WS	
Category	Earthen Levee			GPS Latitude/Longitude		
				Start		End
Item	Animal Control			37.172387 °		37.172387 °
				-120.761190 °		-120.761190 °
DWR ID	DWR_NA0010_02B_f_2018_22					
Comment Code						
A1 : Exterminate rodents and backfill and compact or grout burrows.						
Inspector Comment						
There are several rodent burrows observed at this location

Representative view of rodent burrows. (Fall 2018)

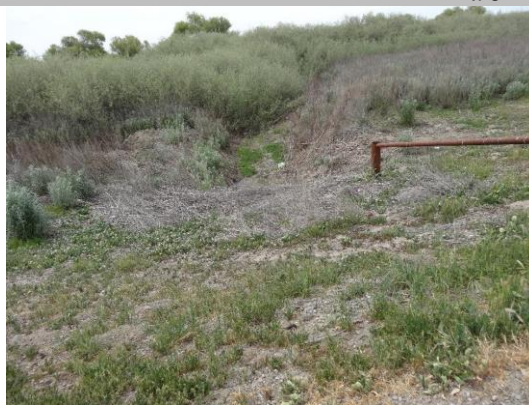
Photo 2 of 3 : UCIP\_SP\_2019\_34083\_61940.jpg

LM Start	<b>0.42</b>	Rating **	M	Issue No.	<b>68 (cont)</b>
LM End	<b>0.42</b>	Issue Type +	Ma	Location *

View of waterward side.

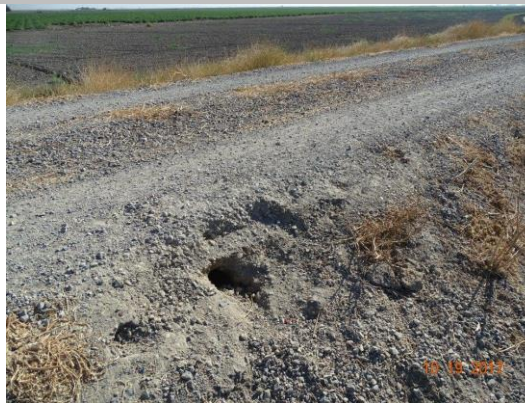
Photo 1 of 1 : SP\_2019\_NA0010\_121\_7\_20190307\_00003.jpg

LM Start	0.83	Rating **	M	Issue No.	7
LM End	0.83	Issue Type +	Ma	Location *	CR
Category	Earthen Levee			GPS Latitude/Longitude	
				Start	End
Item	Animal Control			37.102190 °	37.102190 °
				-120.580717 °	-120.580717 °
DWR ID	DWR_NA0010_03_f_2017_7				
Comment Code					
A1 : Exterminate rodents and backfill and compact or grout burrows.					
Inspector Comment

Looking southeast at the waterside shoulder.

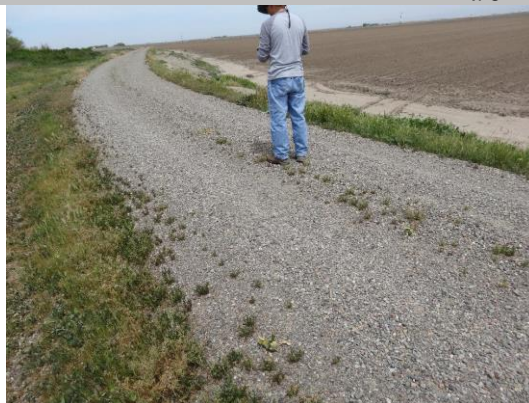
Photo 1 of 3 : UCIP\_SP\_2019\_39371\_66252.jpg

LM Start	1.71	Rating **	M	Issue No.	70
LM End	1.71	Issue Type +	Ma	Location *	
Category	Supplemental			GPS Latitude/Longitude	
				Start	End
Item	DWR UCIP LMA Responsibility			37.092079 °	37.092079 °
				-120.572316 °	-120.572316 °
DWR ID	19693				
Comment Code					
Inspector Comment					
FS_ID:39371					
DS_ID:19693					
EP_NO: N/A					
Repair Type: Non-Urgent					
Crossing Status: Found					
UCIP Comments: 04/17/2014 Sediment buildup in pipe visible from landward side--recommend clearing. (DWR UCIP - O. Magana)					
FIELD_STRUCT_DESC: 24-inch corrugated metal gravity drainage pipe through the levee, 6.8 feet below the crown. Flap gate on the waterside (WS) end. [Additional Reference(s): DWR Levee Log, 2002. USACE San Joaquin O&M Manual 601.1, 1967, (HLM 1.72)].					
FS Date: 4/17/2014

View of levee crown at crossing.

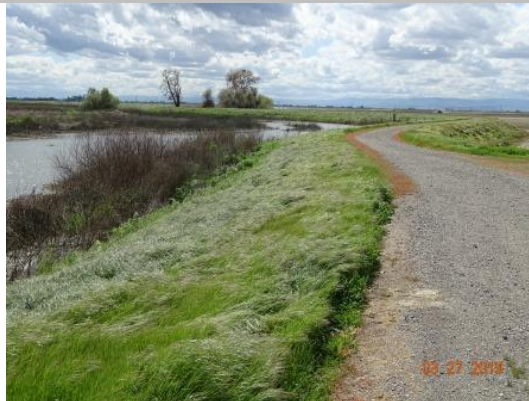
Photo 1 of 1 : SP\_2019\_NA0010\_122\_10\_20190416\_00025.jpg

LM Start	0.05	Rating **	M	Issue No.	10
LM End	0.32	Issue Type +	Ma	Location *	WS
Category	Earthen Levee			GPS Latitude/Longitude	
				Start	End
Item	Vegetation			37.112255 °	37.108807 °
				-120.589794 °	-120.590752 °
DWR ID	DWR_NA0010_04_s_2019_10				
Comment Code					
V1 : Control annual grass and weeds on the levee slopes and easements.					
Inspector Comment

View of waterside slope looking upstream. (Spring 2019)

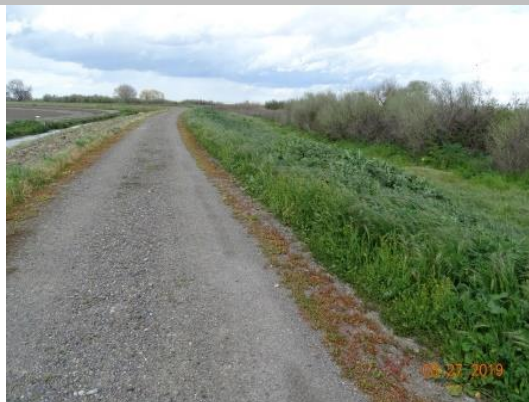
Photo 1 of 1 : SP\_2019\_NA0010\_122\_12\_20190416\_00027.jpg

LM Start	0.32	Rating **	U	Issue No.	12
LM End	1.40	Issue Type +	Ma	Location *	WS
Category	Earthen Levee			GPS Latitude/Longitude	
				Start	End
Item	Vegetation			37.108807 °	37.097702 °
				-120.590752 °	-120.578154 °
DWR ID	DWR_NA0010_04_s_2019_12				
Comment Code					
V1 : Control annual grass and weeds on the levee slopes and easements.					
Inspector Comment

View of waterside slope looking downstream. (Spring 2019)

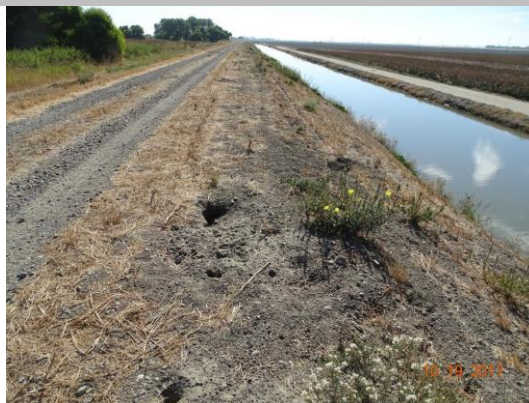
Photo 1 of 1 : SP\_2019\_NA0010\_122\_8\_20190307\_00004.jpg

LM Start	0.55	Rating **	M	Issue No.	8
LM End	0.55	Issue Type +	Ma	Location *	LS
Category	Earthen Levee			GPS Latitude/Longitude	
				Start	End
Item	Animal Control			37.105957 °	37.105957 °
				-120.588684 °	-120.588684 °
DWR ID	DWR_NA0010_04_f_2017_8				
Comment Code					
A3 : No rodents visible, but rodent burrows visible; need to backfill and compact or grout burrows.					
Inspector Comment

Looking south at landside slope.

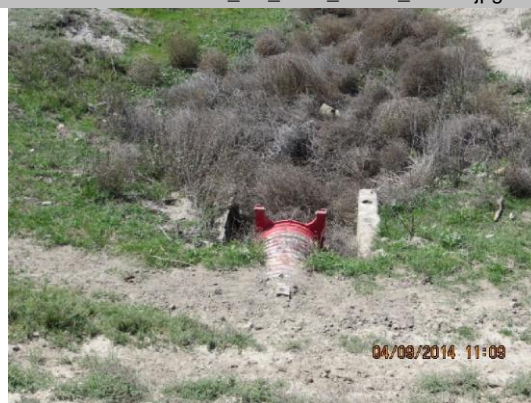
Photo 1 of 3 : UCIP\_SP\_2019\_39563\_60921.jpg

LM Start	0.08	Rating **	M	Issue No.	1310
LM End	0.08	Issue Type +	Ma	Location *	
Category	Supplemental			GPS Latitude/Longitude	
				Start	End
Item	DWR UCIP LMA Responsibility			37.278174 °	37.278174 °
				-120.823465 °	-120.823465 °
DWR ID	19756				
Comment Code					
Inspector Comment					
FS_ID:39563 DS_ID:19756 EP_NO: N/A Repair Type: Non-Urgent Crossing Status: Found UCIP Comments: 04/09/2014 Debris blocking landward headwall--recommend clearing. (DWR UCIP - W. Wylie) FIELD_STRUCT_DESC: 24-inch corrugated metal gravity drainage pipe through the levee, 8.6 feet below the crown. Concrete U-shaped headwall and flap gate on the waterside (WS) end. Concrete headwall on the landside (LS) end. [Additional Reference(s): DWR Levee Log, 2002. USACE San Joaquin O&M Manual 601.1, 1967, (HLM 0.07)]. FS Date: 4/9/2014

Pipe, flapgate, and concrete headwall on WS toe.

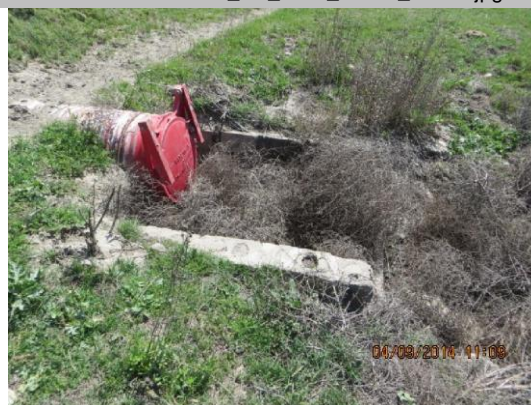
Photo 2 of 3 : UCIP\_SP\_2019\_39563\_60920.jpg

Pipe, flapgate, and concrete headwall on WS toe.

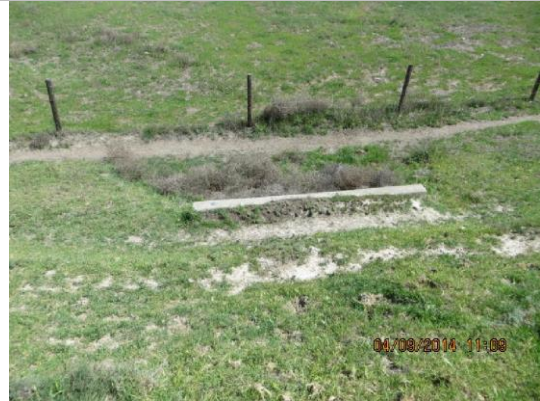
Photo 3 of 3 : UCIP\_SP\_2019\_39563\_60922.jpg

LM Start	0.08	Rating **	M	Issue No.	1310 (cont)	
LM End	0.08	Issue Type +	Ma	Location *		
Category	Supplemental			GPS Latitude/Longitude		
				Start		End
Item	DWR UCIP LMA Responsibility			37.278174 °		37.278174 °
				-120.823465 °		-120.823465 °
DWR ID	19756					
Comment Code						
Inspector Comment						
FS_ID:39563 DS_ID:19756 EP_NO: N/A Repair Type: Non-Urgent Crossing Status: Found UCIP Comments: 04/09/2014 Debris blocking landward headwall--recommend clearing. (DWR UCIP - W. Wylie) FIELD_STRUCT_DESC: 24-inch corrugated metal gravity drainage pipe through the levee, 8.6 feet below the crown. Concrete U-shaped headwall and flap gate on the waterside (WS) end. Concrete headwall on the landside (LS) end. [Additional Reference(s): DWR Levee Log, 2002. USACE San Joaquin O&M Manual 601.1, 1967, (HLM 0.07)]. FS Date: 4/9/2014

Pipe and concrete headwall on LS toe.

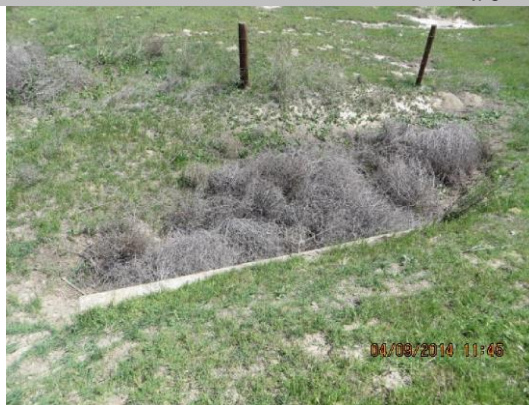
Photo 3 of 3 : UCIP\_SP\_2019\_39584\_60927.jpg

Pipe and concrete headwall on LS toe. Note vegetation buildup.

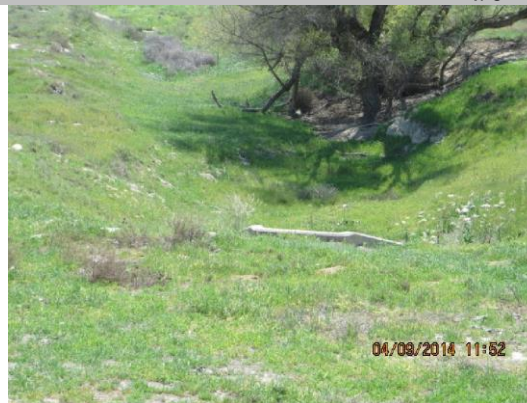
Photo 1 of 3 : UCIP\_SP\_2019\_39585\_60931.jpg

Comment Code					
Inspector Comment					
FS_ID:39585 DS_ID:19758 EP_NO: N/A Repair Type: Non-Urgent Crossing Status: Found UCIP Comments: 04/09/2014 Dense vegetation limits the inspector's visibility to identify signs of pipe failure (leaks) along the landward slope. Recommend removing vegetation along pipe alignment to conduct proper inspection of structure. (DWR UCIP - W. Wylie) FIELD_STRUCT_DESC: 36-inch corrugated metal gravity drainage pipe through the levee, 13.2 feet below the crown. Flap gate on the waterside (WS) end. Concrete headwall on the landside (LS) end. Concrete U-shaped headwall on the WS end. Cobble revetment around both ends. [Additional Reference(s): DWR Levee Log, 2002. USACE San Joaquin O&M Manual 601.1, 1967, (HLM 0.65)]. FS Date: 4/9/2014

Concrete headwall visible off WS toe.

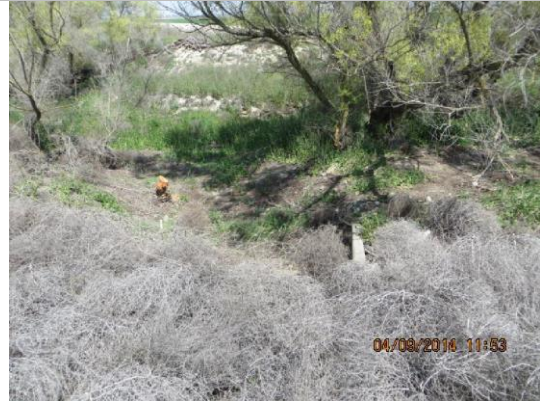
Photo 3 of 3 : UCIP\_SP\_2019\_39585\_60930.jpg

Comment Code						
Inspector Comment						
FS_ID:39585						
DS_ID:19758						
EP_NO: N/A						
Repair Type: Non-Urgent						
Crossing Status: Found						
UCIP Comments: 04/09/2014 Dense vegetation limits the inspector's visibility to identify signs of pipe failure (leaks) along the landward slope.						
Recommend removing vegetation along pipe alignment to conduct proper inspection of structure. (DWR UCIP - W. Wylie)						
FIELD_STRUCT_DESC: 36-inch corrugated metal gravity drainage pipe through the levee, 13.2 feet below the crown. Flap gate on the waterside (WS) end. Concrete headwall on the landside (LS) end. Concrete U-shaped headwall on the WS end. Cobble revetment around both ends. [Additional Reference(s): DWR Levee Log, 2002. USACE San Joaquin O&M Manual 601.1, 1967, (HLM 0.65)].						
FS Date: 4/9/2014

Concrete headwall at LS toe.

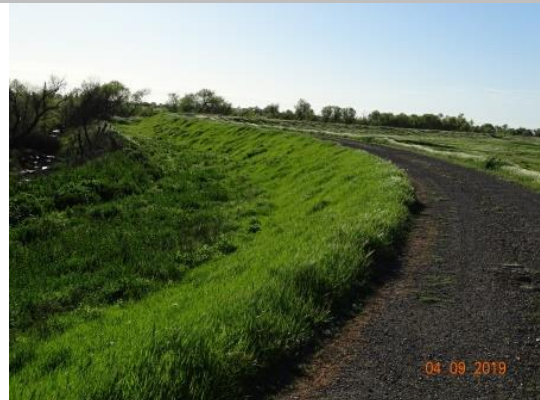
Photo 1 of 1 : SP\_2019\_NA0010\_123\_100\_20190422\_00334.jpg

LM Start	0.66	Rating **	M	Issue No.	100
LM End	3.63	Issue Type +	Ma	Location *	LS
Category	Earthen Levee			GPS Latitude/Longitude	
				Start	End
Item	Vegetation			37.273299 °	37.252951 °
				-120.815011 °	-120.768351 °
DWR ID	DWR_NA0010_05_s_2019_100				
Comment Code					
V1 : Control annual grass and weeds on the levee slopes and easements.					
Inspector Comment

View of landside slope looking upstream. (Spring 2019)

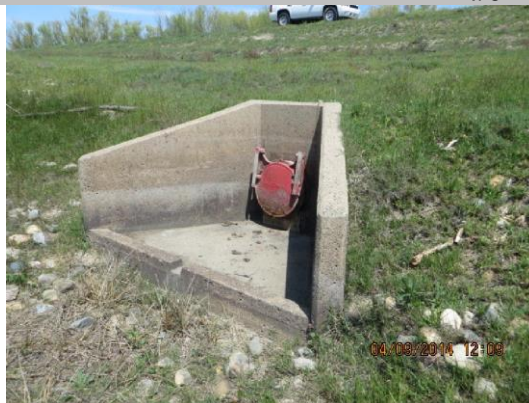
Photo 2 of 3 : UCIP\_SP\_2019\_33707\_60933.jpg

LM Start	0.85	Rating **	A/W	Issue No.	1315 (cont)
LM End	0.85	Issue Type +	Ma	Location *	
Category	Supplemental			GPS Latitude/Longitude	
				Start	End
Item	DWR UCIP LMA Responsibility			37.271894 °	37.271894 °
				-120.812224 °	-120.812224 °
DWR ID	19759				
Comment Code					
Inspector Comment					
FS_ID:33707 DS_ID:19759 EP_NO: N/A Repair Type: No Action Needed Crossing Status: Found UCIP Comments: FIELD_STRUCT_DESC: 24-inch corrugated metal gravity drainage pipe through the levee, 14.4 feet below the crown. Flap gate on the waterside (WS) end. Concrete headwall on the landside (LS) end. Concrete U-shaped headwall on the WS end. [Additional Reference(s): DWR Levee Log, 2002. USACE San Joaquin O&M Manual 601.1, 1967, (HLM 0.84)]. FS Date: 4/9/2014

Pipe, flapgate, and headwall at WS toe.

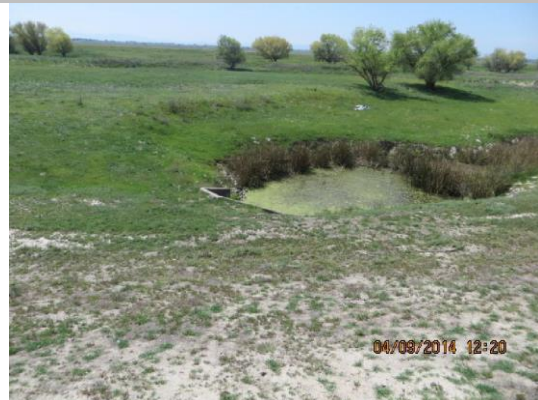
Photo 1 of 3 : UCIP\_SP\_2019\_33708\_60939.jpg

LM Start	1.45	Rating **	A/W	Issue No.	1316
LM End	1.45	Issue Type +	Ma	Location *	
Category	Supplemental			GPS Latitude/Longitude	
				Start	End
Item	DWR UCIP LMA Responsibility			37.265804 °	37.265804 °
				-120.804955 °	-120.804955 °
DWR ID	19760				
Comment Code					
Inspector Comment					
FS_ID:33708					
DS_ID:19760					
EP_NO: N/A					
Repair Type: No Action Needed					
Crossing Status: Found					
UCIP Comments:					
FIELD_STRUCT_DESC: 36-inch corrugated metal gravity drainage pipe through the levee, 21 feet below the crown. Flap gate on the waterside (WS) end. Concrete headwall on the landside (LS) end. Concrete U-shaped headwall on the WS end. [Additional Reference(s): DWR Levee Log, 2002. USACE San Joaquin O&M Manual 601.1, 1967, (HLM 1.44)].					
FS Date: 4/9/2014

Flapgate on concrete headwall at WS toe.

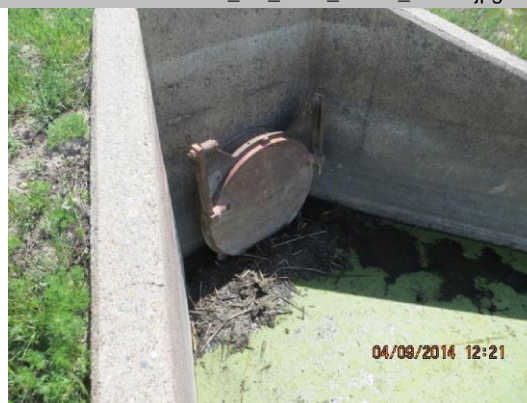
Photo 2 of 3 : UCIP\_SP\_2019\_33708\_60938.jpg

LM Start	1.45	Rating **	A/W	Issue No.	1316 (cont)	
LM End	1.45	Issue Type +	Ma	Location *		
Category	Supplemental			GPS Latitude/Longitude		
				Start	End	
Item	DWR UCIP LMA Responsibility			37.265804 °	37.265804 °	
				-120.804955 °	-120.804955 °	
DWR ID	19760					
Comment Code						
Inspector Comment						
FS_ID:33708						
DS_ID:19760						
EP_NO: N/A						
Repair Type: No Action Needed						
Crossing Status: Found						
UCIP Comments:						
FIELD_STRUCT_DESC: 36-inch corrugated metal gravity drainage pipe through the levee, 21 feet below the crown. Flap gate on the waterside (WS) end. Concrete headwall on the landside (LS) end. Concrete U-shaped headwall on the WS end. [Additional Reference(s): DWR Levee Log, 2002. USACE San Joaquin O&M Manual 601.1, 1967, (HLM 1.44)].						
FS Date: 4/9/2014

Flapgate on concrete headwall at WS toe.

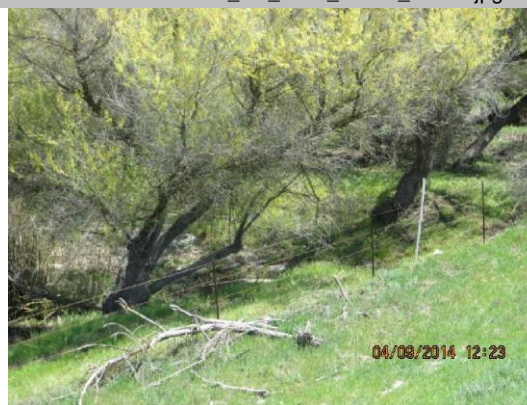
Photo 3 of 3 : UCIP\_SP\_2019\_33708\_60937.jpg

Pipe and concrete headwall on LS toe.

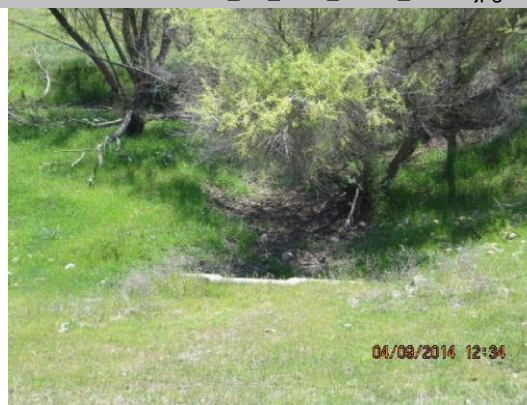
Photo 1 of 3 : UCIP\_SP\_2019\_33709\_60943.jpg

LM Start	2.84	Rating **	M	Issue No.	1317
LM End	2.84	Issue Type +	Ma	Location *	
Category	Supplemental			GPS Latitude/Longitude	
				Start	End
Item	DWR UCIP LMA Responsibility			37.256810 °	37.256810 °
				-120.785113 °	-120.785113 °
DWR ID	19809				
Comment Code					
Inspector Comment					
FS_ID:33709 DS_ID:19809 EP_NO: N/A Repair Type: Non-Urgent Crossing Status: Found UCIP Comments: 04/09/2014 Log partially blocking inlet at LS toe. (DWR UCIP - W. Wylie) FIELD_STRUCT_DESC: 24-inch corrugated metal gravity drainage pipe through the levee, 15 feet below the crown. Flap gate on the waterside (WS) end. Concrete U-shaped headwall on each end. [Additional Reference(s): DWR Levee Log, 2002. USACE San Joaquin O&M Manual 601.1, 1967, (HLM 2.85)]. FS Date: 4/9/2014

Concrete headwall at outlet on WS toe.

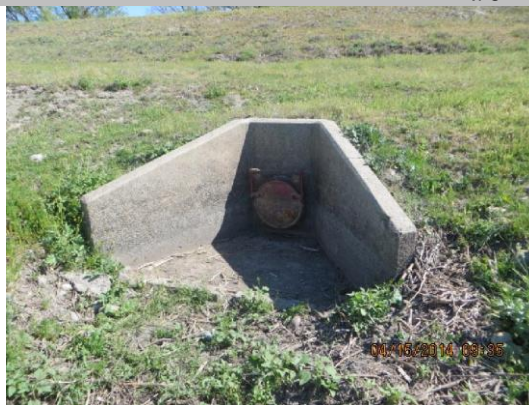
Photo 2 of 3 : UCIP\_SP\_2019\_43055\_60946.jpg

Flapgate and Concrete headwall at WS toe.

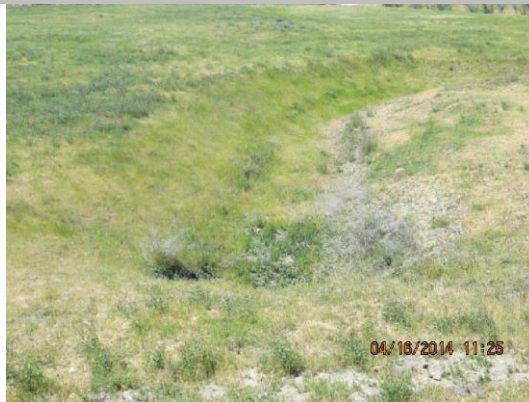
Photo 3 of 3 : UCIP\_SP\_2019\_39586\_61136.jpg

Pipe and headwall on LS toe.

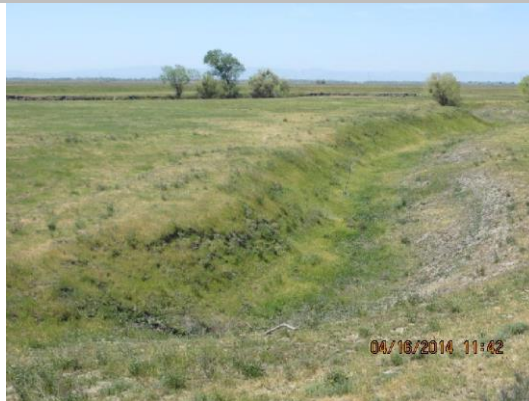
Photo 1 of 3 : UCIP\_SP\_2019\_39880\_61142.jpg

LM Start	4.02	Rating **	M	Issue No.	1320
LM End	4.02	Issue Type +	Ma	Location *	
Category	Supplemental			GPS Latitude/Longitude	
				Start	End
Item	DWR UCIP LMA Responsibility		37.248432 °	37.248432 °	
			-120.764066 °	-120.764066 °	
DWR ID	19769				
Comment Code					
Inspector Comment					
FS_ID:39880 DS_ID:19769 EP_NO: N/A Repair Type: Non-Urgent Crossing Status: Found UCIP Comments: 04/16/2014 Sediment buildup in pipe visible from landward side--recommend contacting owner to clear pipe. (DWR UCIP - W. Wylie) FIELD_STRUCT_DESC: 24-inch corrugated metal gravity drainage pipe through the levee, 16 feet below the crown. Flap gate on the waterside (WS) end. Concrete U-shaped headwall on each end. [Additional Reference(s): DWR Levee Log, 2002. USACE San Joaquin O&M Manual 601.1, 1967, (HLM 4.02)]. FS Date: 4/16/2014

Pipe, headwall, and flapgate on WS toe.

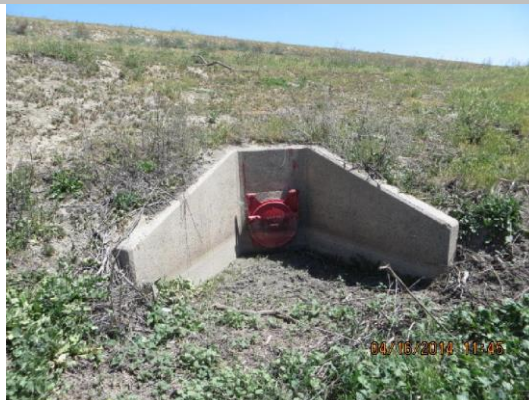
Photo 2 of 3 : UCIP\_SP\_2019\_39880\_61143.jpg

Pipe, headwall, and flapgate on WS toe.

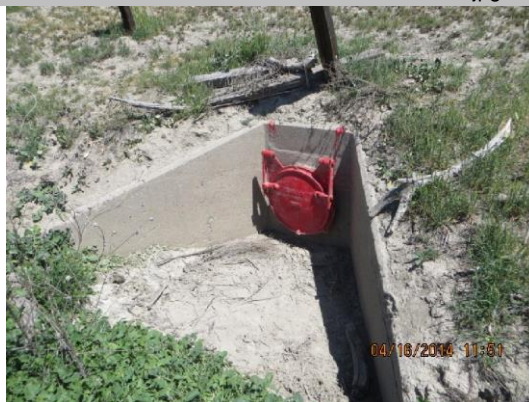
Photo 2 of 3 : UCIP\_SP\_2019\_39588\_61145.jpg

Pipe, headwall, and flapgate on WS toe.

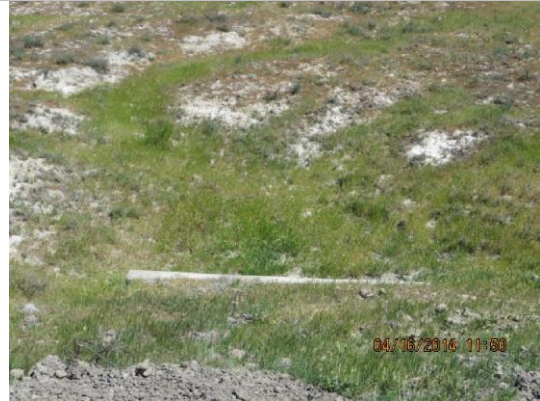
Photo 3 of 3 : UCIP\_SP\_2019\_39588\_61147.jpg

Concrete headwall and pipe on LS toe.

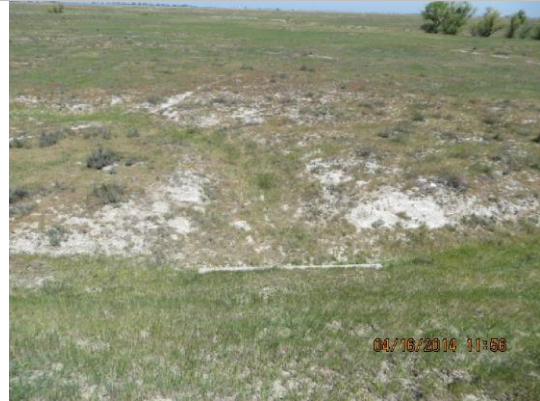
Photo 3 of 3 : UCIP\_SP\_2019\_39589\_62082.jpg

Comment Code					
Inspector Comment					
FS_ID:39589					
DS_ID:19771					
EP_NO: N/A					
Repair Type: Non-Urgent					
Crossing Status: Found					
UCIP Comments: 04/16/2014 Sediment buildup in pipe visible from landward side--recommend contacting owner to clear pipe. (DWR UCIP - W. Wylie)					
FIELD_STRUCT_DESC: 24-inch corrugated metal gravity drainage pipe through the levee, 12 feet below the crown. Flap gate on the waterside (WS) end. Concrete headwall on the landside (LS) end. Concrete U-shaped headwall on the WS end. [Additional Reference(s): DWR Levee Log, 2002. USACE San Joaquin O&M Manual 601.1, 1967, (HLM 4.54)].					
FS Date: 4/16/2014 8:16:00 AM

Pipe and headwall on LS toe.

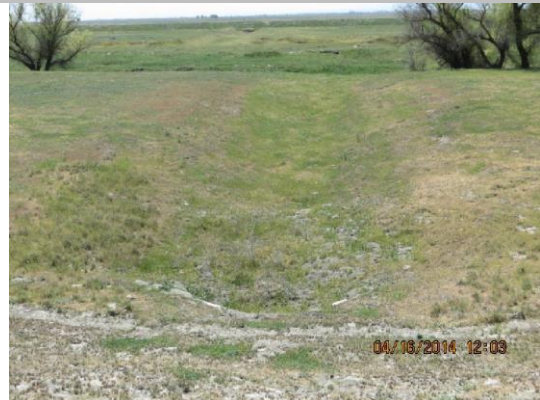
Photo 1 of 3 : UCIP\_SP\_2019\_39590\_62087.jpg

LM Start	4.89	Rating **	M	Issue No.	1323	
LM End	4.89	Issue Type +	Ma	Location *		
Category	Supplemental			GPS Latitude/Longitude		
				Start		End
Item	DWR UCIP LMA Responsibility			37.240978 °	37.240978 °	
				-120.751613 °	-120.751613 °	
DWR ID	19772					
Comment Code						
Inspector Comment						
FS_ID:39590 DS_ID:19772 EP_NO: N/A Repair Type: Non-Urgent Crossing Status: Found UCIP Comments: 04/16/2014 Heavy sediment buildup in pipe visible from landward side--recommend contacting owner to clear pipe. (DWR UCIP - W. Wylie) FIELD_STRUCT_DESC: 24-inch corrugated metal gravity drainage pipe through the levee, 12.3 feet below the crown. Flap gate on the waterside (WS) end. Concrete headwall on the landside (LS) end. Concrete U-shaped headwall on the WS end. [Additional Reference(s): DWR Levee Log, 2002. USACE San Joaquin O&M Manual 601.1, 1967, (HLM 4.89)]. FS Date: 4/16/2014

Headwall, flapgate, and pipe on WS toe.

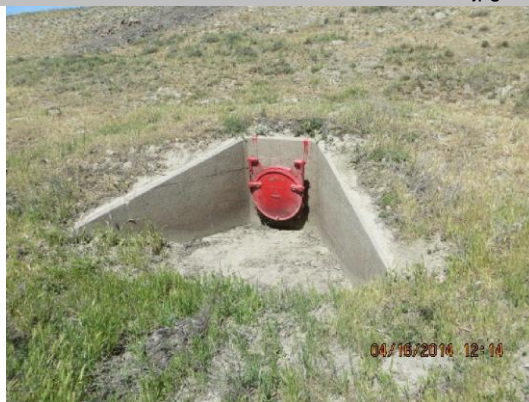
Photo 2 of 3 : UCIP\_SP\_2019\_39591\_62093.jpg

Headwall, flapgate, and pipe on WS toe.

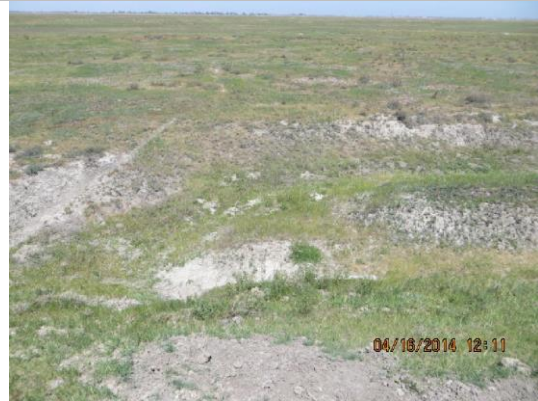
Photo 3 of 3 : UCIP\_SP\_2019\_39591\_62092.jpg

LM Start	5.15	Rating **	M	Issue No.	1324 (cont)	
LM End	5.15	Issue Type +	Ma	Location *		
Category	Supplemental			GPS Latitude/Longitude		
				Start		End
Item	DWR UCIP LMA Responsibility			37.240607 °		37.240607 °
				-120.746916 °		-120.746916 °
DWR ID	19773					
Comment Code						
Inspector Comment						
FS_ID:39591 DS_ID:19773 EP_NO: N/A Repair Type: Non-Urgent Crossing Status: Found UCIP Comments: 04/16/2014 Heavy sediment buildup in pipe visible from landward side--recommend contacting owner to clear pipe. (DWR UCIP - W. Wylie) FIELD_STRUCT_DESC: 24-inch corrugated metal gravity drainage pipe through the levee, 12.2 feet below the crown. Flap gate on the waterside (WS) end. Concrete headwall on the landside (LS) end. Concrete U-shaped headwall on the WS end. [Additional Reference(s): DWR Levee Log, 2002. USACE San Joaquin O&M Manual 601.1, 1967, (HLM 5.15)]. FS Date: 4/16/2014

Headwall and pipe on LS toe.

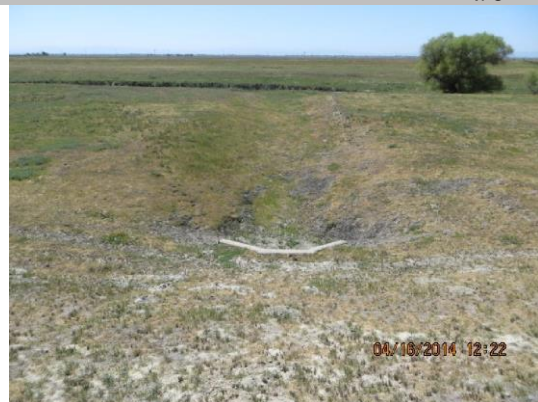
Photo 1 of 3 : UCIP\_SP\_2019\_34151\_62096.jpg

LM Start	5.58	Rating **	A/W	Issue No.	1325
LM End	5.58	Issue Type +	Ma	Location *	
Category	Supplemental			GPS Latitude/Longitude	
				Start	End
Item	DWR UCIP LMA Responsibility			37.238879 °	37.238879 °
				-120.739719 °	-120.739719 °
DWR ID	19774				
Comment Code					
Inspector Comment					
FS_ID:34151					
DS_ID:19774					
EP_NO: N/A					
Repair Type: No Action Needed					
Crossing Status: Found					
UCIP Comments:					
FIELD_STRUCT_DESC: 24-inch corrugated metal gravity drainage pipe through the levee, 9.5 feet below the crown. Flap gate on the waterside (WS) end. Concrete headwall on the landside (LS) end. Concrete U-shaped headwall on the WS end. [Additional Reference(s): DWR Levee Log, 2002. USACE San Joaquin O&M Manual 601.1, 1967, (HLM 5.58)].					
FS Date: 4/16/2014

Headwall, flapgate, and pipe on WS toe.
