**Flood Control Project Maintenance  
Levee Inspections**

## Maintenance Issue Types Only, Levee Inspection Report By Mile - Spring 2019

### Lower San Joaquin Levee District

Waterway	Bank	Unit Miles	Inspection Start/End	Inspector
Unit No. 01 San Joaquin River	Right	22.52	03/26/2019 03/26/2019	Corey Fujitani

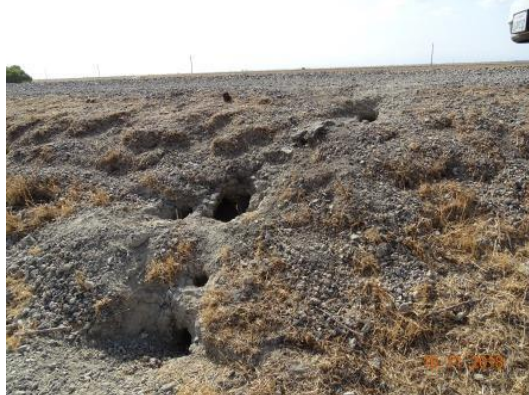
Photo 1 of 2 : SP\_2019\_NA0010\_123\_138\_20190307\_00036.jpg

LM Start	5.94	Rating **	U	Issue No.	138
LM End	5.94	Issue Type +	Ma	Location *	LS
Category	Earthen Levee			GPS Latitude/Longitude	
				Start	End
Item	Animal Control			37.236387 °	37.236387 °
				-120.734164 °	-120.734164 °
DWR ID	DWR_NA0010_05_f_2018_138				
Comment Code					
A1 : Exterminate rodents and backfill and compact or grout burrows.					
Inspector Comment					
Several large rodent holes are located at this location.

View of large rodent holes in landside slope. (Fall 2018)

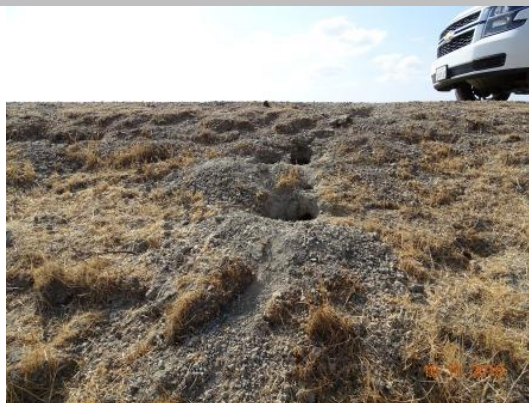
Photo 2 of 2 : SP\_2019\_NA0010\_123\_138\_20190307\_00037.jpg

View of large rodent holes in landside slope. (Fall 2018)

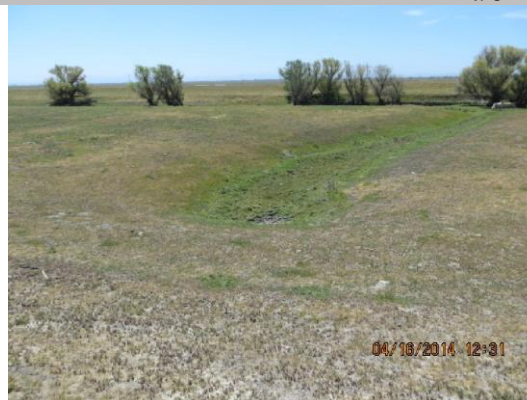
Photo 1 of 3 : UCIP\_SP\_2019\_34163\_62102.jpg

LM Start	6.35	Rating **	A/W	Issue No.	1326
LM End	6.35	Issue Type +	Ma	Location *	
Category	Supplemental			GPS Latitude/Longitude	
				Start	End
Item	DWR UCIP LMA Responsibility			37.232589 °	37.232589 °
				-120.728822 °	-120.728822 °
DWR ID	19775				
Comment Code					
Inspector Comment					
FS_ID:34163 DS_ID:19775 EP_NO: N/A Repair Type: No Action Needed Crossing Status: Found UCIP Comments: FIELD_STRUCT_DESC: 24-inch corrugated metal gravity drainage pipe through the levee, 13 feet below the crown. Flap gate on the waterside (WS) end. Concrete headwall on the landside (LS) end. Concrete U-shaped headwall on the WS end. [Additional Reference(s): DWR Levee Log, 2002. USACE San Joaquin O&M Manual 601.1, 1967, (HLM 6.35)]. FS Date: 4/16/2014

Headwall, flapgate, and pipe on WS toe.

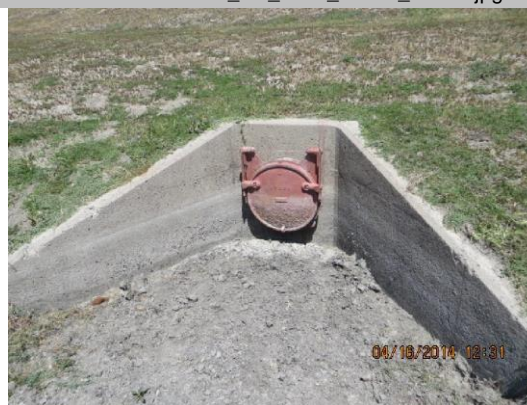
Photo 2 of 3 : UCIP\_SP\_2019\_34163\_62101.jpg

Headwall, flapgate, and pipe on WS toe.

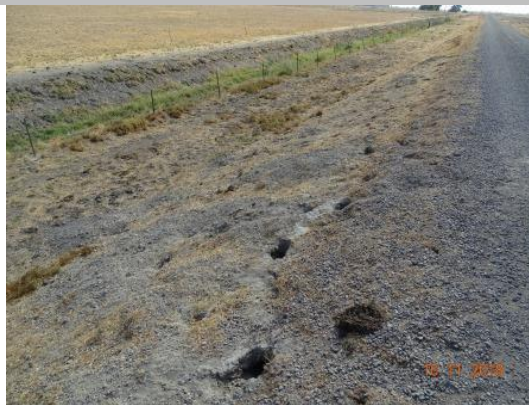
Photo 1 of 2 : SP\_2019\_NA0010\_123\_139\_20190307\_00038.jpg

LM Start	6.40	Rating **	M	Issue No.	139
LM End	6.40	Issue Type +	Ma	Location *	LS
Category	Earthen Levee			GPS Latitude/Longitude	
				Start	End
Item	Animal Control			37.231900 °	37.231900 °
				-120.728345 °	-120.728345 °
DWR ID	DWR_NA0010_05_f_2018_139				
Comment Code					
A1 : Exterminate rodents and backfill and compact or grout burrows.					
Inspector Comment

View of rodent holes on landside shoulder. (Fall 2018)

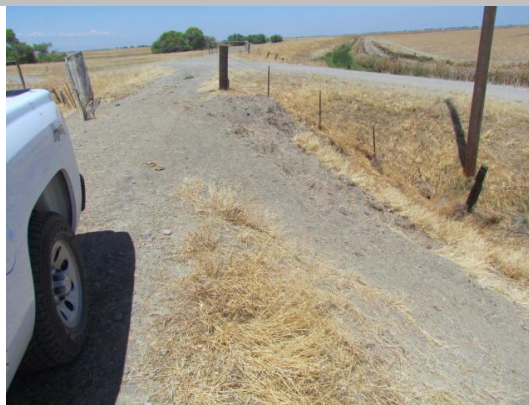
Photo 2 of 3 : SP\_2019\_NA0010\_123\_1309\_20190307\_00065.jpg

Looking north at damaged landward slope.

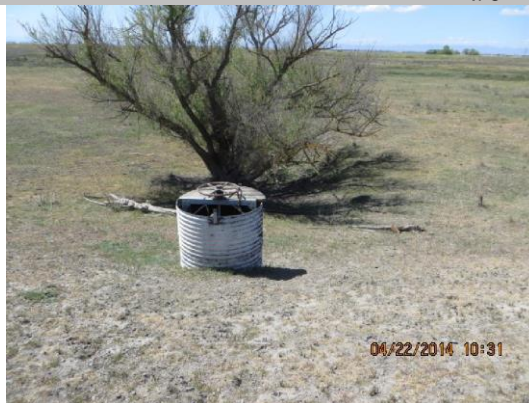
Photo 1 of 3 : UCIP\_SP\_2019\_34272\_62196.jpg

LM Start	9.28	Rating **	A/W	Issue No.	1331
LM End	9.28	Issue Type +	Ma	Location *	
Category	Supplemental			GPS Latitude/Longitude	
				Start	End
Item	DWR UCIP LMA Responsibility			37.202742 °	37.202742 °
				-120.690064 °	-120.690064 °
DWR ID	19766				
Comment Code					
Inspector Comment					
FS_ID:34272					
DS_ID:19766					
EP_NO: N/A					
Repair Type: No Action Needed					
Crossing Status: Found					
UCIP Comments:					
FIELD_STRUCT_DESC: 36-inch corrugated metal gravity drainage pipe through the levee, 14.8 feet below the crown. Slide gate in a 48-inch corrugated metal pipe (CMP) riser on the waterside (WS) slope. Concrete headwall on each end. [Additional Reference(s): DWR Levee Log, 2002. USACE San Joaquin O&M Manual 601.1, 1967, (HLM 9.26)].					
FS Date: 4/22/2014

Slide gate in 48-inch CMP riser on WS slope.

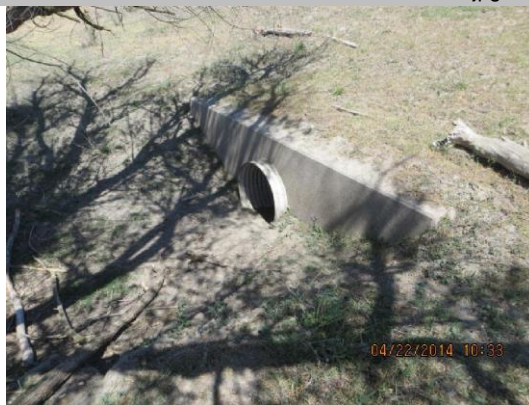
Photo 2 of 3 : UCIP\_SP\_2019\_34272\_62198.jpg

Headwall and pipe at WS toe.

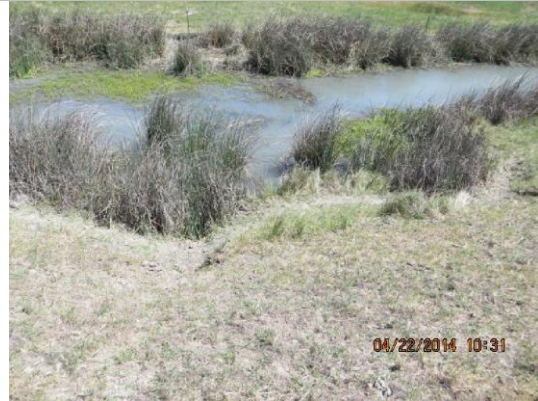
Photo 3 of 3 : UCIP\_SP\_2019\_34272\_62197.jpg

Headwall and pipe at LS toe.

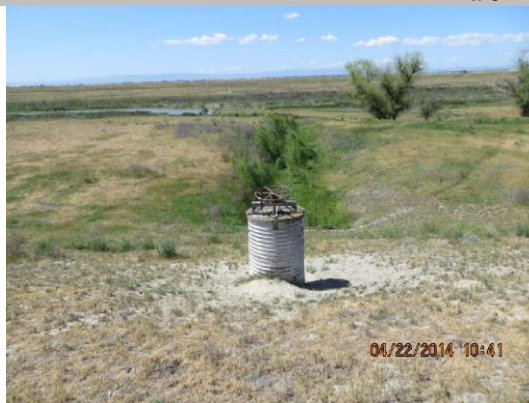
Photo 1 of 3 : UCIP\_SP\_2019\_34273\_62201.jpg

LM Start	10.06	Rating **	M	Issue No.	1332
LM End	10.06	Issue Type +	Ma	Location *	
Category	Supplemental			GPS Latitude/Longitude	
				Start	End
Item	DWR UCIP LMA Responsibility			37.194736 °	37.194736 °
				-120.680116 °	-120.680116 °
DWR ID	19767				
Comment Code					
Inspector Comment					
FS_ID:34273					
DS_ID:19767					
EP_NO: N/A					
Repair Type: Non-Urgent					
Crossing Status: Found					
UCIP Comments: 04/22/2014 Slidegate actuator appears bent and may not work properly (WS slope). (DWR UCIP - W. Wylie)					
FIELD_STRUCT_DESC: 24-inch corrugated metal gravity drainage pipe through the levee, 15 feet below the crown. Slide gate in a 36-inch corrugated metal pipe (CMP) riser on the waterside (WS) slope.					
Concrete headwall on each end. [Additional Reference(s): DWR Levee Log, 2002. USACE San Joaquin O&M Manual 601.1, 1967, (HLM 10.05)].					
FS Date: 4/22/2014

Slidegate in CMP riser on WS slope.

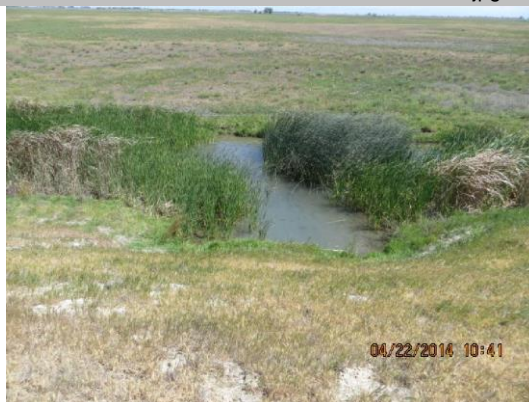
Photo 3 of 3 : UCIP\_SP\_2019\_34273\_62200.jpg

Concrete headwall and pipe on LS toe.

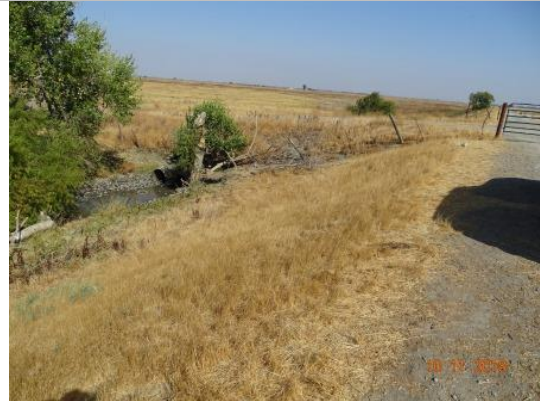
Photo 1 of 1 : SP\_2019\_NA0010\_123\_142\_20190307\_00041.jpg

LM Start	10.66	Rating **	M	Issue No.	142
LM End	10.66	Issue Type +	Ma	Location *	LS
Category	Earthen Levee			GPS Latitude/Longitude	
				Start	End
Item	Encroachments			37.190286 °	37.190286 °
				-120.671207 °	-120.671207 °
DWR ID	DWR_NA0010_05_f _ 2018_142				
Comment Code					
TR : Tree or limb					
Inspector Comment					
A fallen tree is located on the landside toe and slope.

Fallen tree on landside toe and slope. (Fall 2018)

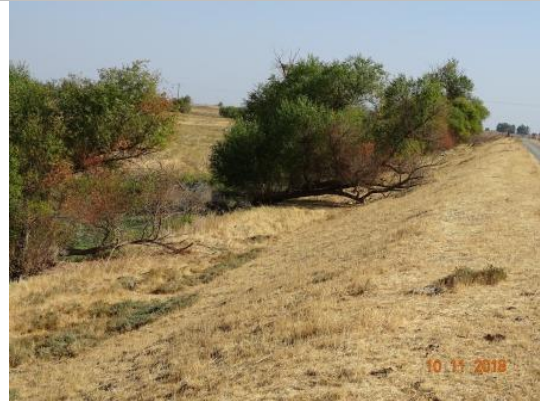
Photo 1 of 1 : SP\_2019\_NA0010\_123\_144\_20190307\_00042.jpg

LM Start	11.37	Rating **	M	Issue No.	144
LM End	11.37	Issue Type +	Ma	Location *	LS
Category	Earthen Levee			GPS Latitude/Longitude	
				Start	End
Item	Trim / Thin Trees			37.187792 °	37.187792 °
				-120.659454 °	-120.659454 °
DWR ID	DWR_NA0010_05_f_2018_144				
Comment Code					
T2 : Thin trees to allow visibility of the ground and room to flood fight.					
Inspector Comment					
Tree limbs on the levee slope should be trimmed to allow access.

View of tree limbs on levee slope. (Fall 2018)

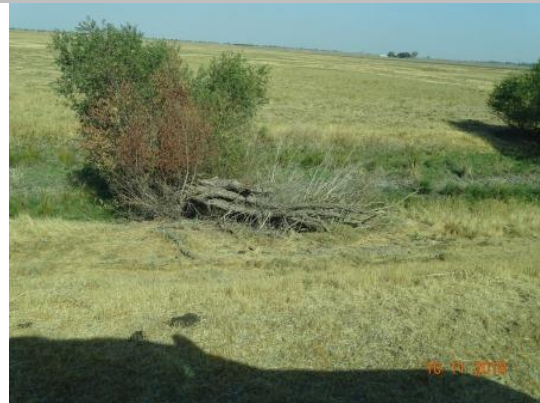
Photo 1 of 1 : SP\_2019\_NA0010\_123\_145\_20190307\_00043.jpg

LM Start	11.41	Rating **	M	Issue No.	145
LM End	11.41	Issue Type +	Ma	Location *	LS
Category	Earthen Levee			GPS Latitude/Longitude	
				Start	End
Item	Trim / Thin Trees			37.187404 °	37.187404 °
				-120.659005 °	-120.659005 °
DWR ID	DWR_NA0010_05_f_2018_145				
Comment Code					
T2 : Thin trees to allow visibility of the ground and room to flood fight.					
Inspector Comment					
A fallen tree trunk is located on the levee toe.

Fallen tree on levee toe. (Fall 2018)

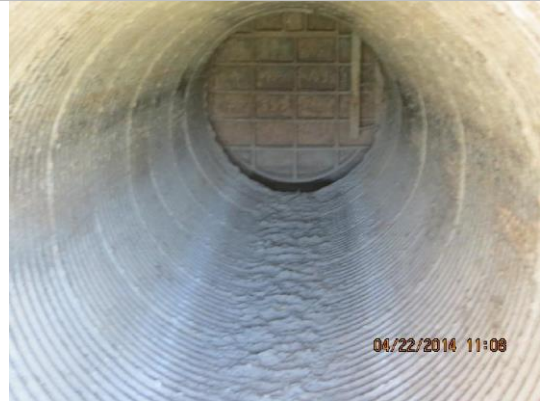
Photo 3 of 3 : UCIP\_SP\_2019\_34281\_62218.jpg

Inside pipe at LS toe.

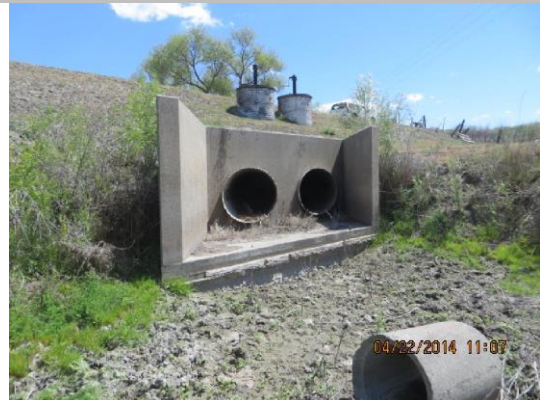
Photo 1 of 3 : UCIP\_SP\_2019\_34280\_62216.jpg

LM Start	11.50	Rating **	A/W	Issue No.	1334
LM End	11.50	Issue Type +	Ma	Location *	
Category	Supplemental			GPS Latitude/Longitude	
				Start	End
Item	DWR UCIP LMA Responsibility			37.186458 °	37.186458 °
				-120.657903 °	-120.657903 °
DWR ID	19734				
Comment Code					
Inspector Comment					
FS_ID:34280 DS_ID:19734 EP_NO: N/A Repair Type: No Action Needed Crossing Status: Found UCIP Comments: FIELD_STRUCT_DESC: [Deadman Drainage Structure] 2 of 2: 48-inch corrugated metal gravity drainage pipe through the levee, 16 feet below the crown. Slide gate in a 60-inch corrugated metal pipe (CMP) riser on the waterside (WS) slope. Concrete U-shaped headwall on each end. Stairs on the landside (LS) slope. [Additional Reference(s): DWR Levee Log, 2002. USACE San Joaquin O&M Manual 601.1, 1967, (HLM 11.48)]. FS Date: 4/22/2014

Concrete headwall, pipe, and slidegate in CMP riser on WS of levee.

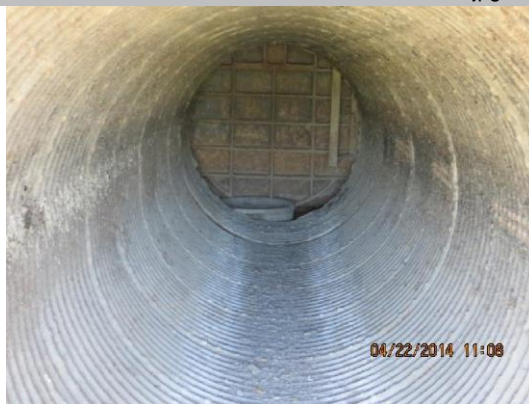
Photo 3 of 3 : UCIP\_SP\_2019\_34280\_62215.jpg

Inside pipe on WS toe.

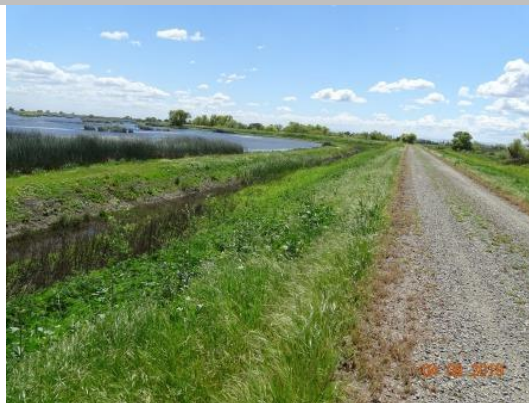
Photo 1 of 1 : SP\_2019\_NA0010\_123\_179\_20190423\_00338.jpg

LM Start	11.55	Rating **	U	Issue No.	179
LM End	14.35	Issue Type +	Ma	Location *	LS
Category	Earthen Levee			GPS Latitude/Longitude	
				Start	End
Item	Vegetation			37.185829 °	37.163394 °
				-120.657181 °	-120.620270 °
DWR ID	DWR_NA0010_05_s_2019_179				
Comment Code					
V1 : Control annual grass and weeds on the levee slopes and easements.					
Inspector Comment

View of landside slope looking upstream. (Spring 2019)

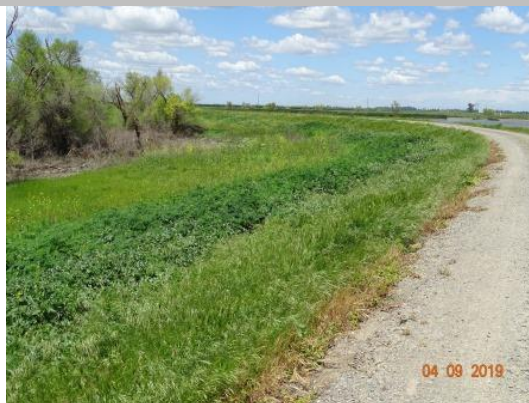
Photo 1 of 1 : SP\_2019\_NA0010\_123\_180\_20190423\_00337.jpg

LM Start	11.55	Rating **	U	Issue No.	180
LM End	14.35	Issue Type +	Ma	Location *	WS
Category	Earthen Levee			GPS Latitude/Longitude	
				Start	End
Item	Vegetation			37.185829 °	37.163394 °
				-120.657181 °	-120.620270 °
DWR ID	DWR_NA0010_05_s_2019_180				
Comment Code					
V1 : Control annual grass and weeds on the levee slopes and easements.					
Inspector Comment

View of waterside slope looking downstream. (Spring 2019)

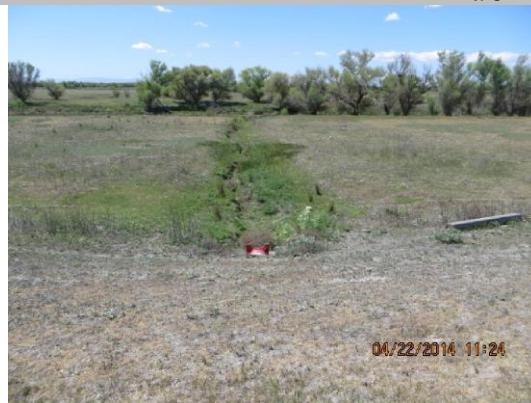
Photo 1 of 3 : UCIP\_SP\_2019\_34283\_62221.jpg

LM Start	11.65	Rating **	A/W	Issue No.	1335
LM End	11.65	Issue Type +	Ma	Location *	
Category	Supplemental			GPS Latitude/Longitude	
				Start	End
Item	DWR UCIP LMA Responsibility			37.184830 °	37.184830 °
				-120.656016 °	-120.656016 °
DWR ID	19704				
Comment Code					
Inspector Comment					
FS_ID:34283 DS_ID:19704 EP_NO: N/A Repair Type: No Action Needed Crossing Status: Found UCIP Comments: FIELD_STRUCT_DESC: 24-inch corrugated metal gravity drainage pipe through the levee, 11.8 feet below the crown. Flap gate on the waterside (WS) end. Concrete headwall on the landside (LS) end. Concrete saddle and apron on the WS end. [Additional Reference(s): DWR Levee Log, 2002. USACE San Joaquin O&M Manual 601.1, 1967, (HLM 11.63)]. FS Date: 4/22/2014

Headwall, flapgate, and pipe at WS toe.

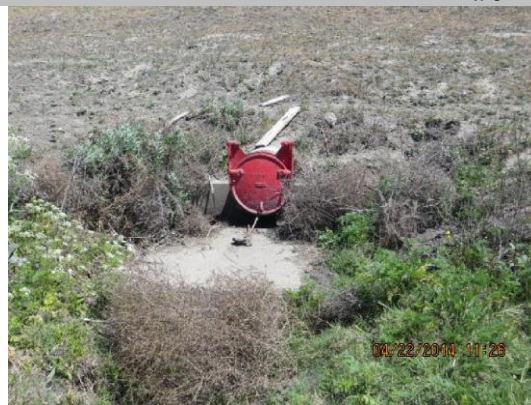
Photo 2 of 3 : UCIP\_SP\_2019\_34283\_62223.jpg

Headwall, flapgate, and pipe at WS toe.

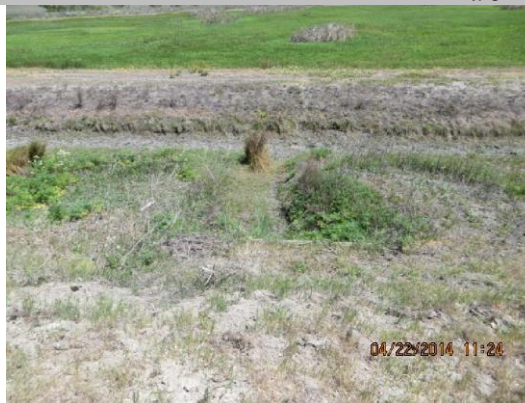
Photo 3 of 3 : UCIP\_SP\_2019\_34283\_62222.jpg

Concrete headwall and pipe at LS toe.

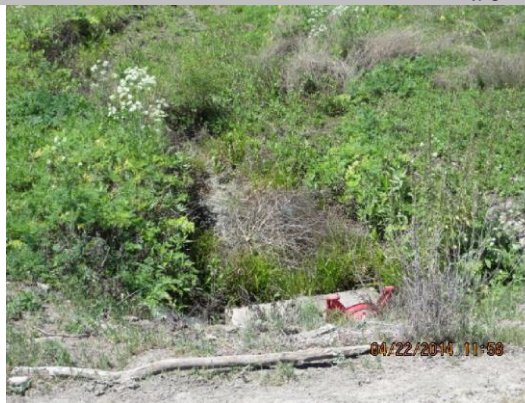
Photo 1 of 3 : UCIP\_SP\_2019\_34284\_62225.jpg

LM Start	12.01	Rating **	A/W	Issue No.	1336
LM End	12.01	Issue Type +	Ma	Location *	
Category	Supplemental			GPS Latitude/Longitude	
				Start	End
Item	DWR UCIP LMA Responsibility			37.180291 °	37.180291 °
				-120.653931 °	-120.653931 °
DWR ID	19705				
Comment Code					
Inspector Comment					
FS_ID:34284 DS_ID:19705 EP_NO: N/A Repair Type: No Action Needed Crossing Status: Found UCIP Comments: FIELD_STRUCT_DESC: 24-inch corrugated metal gravity drainage pipe through the levee, 12.5 feet below the crown. Flap gate on the waterside (WS) end. Concrete headwall on the landside (LS) end. Concrete saddle and apron on the waterside (WS) end. Flashboard attachment on the LS end. [Additional Reference(s): DWR Levee Log, 2002. USACE San Joaquin O&M Manual 601.1, 1967, (HLM 11.99)]. FS Date: 4/22/2014

Headwall, flapgate, and pipe on WS toe.

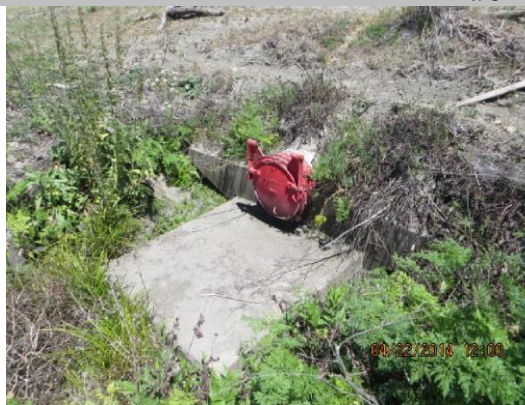
Photo 2 of 3 : UCIP\_SP\_2019\_34284\_62227.jpg

Headwall, flapgate, and pipe on WS toe.

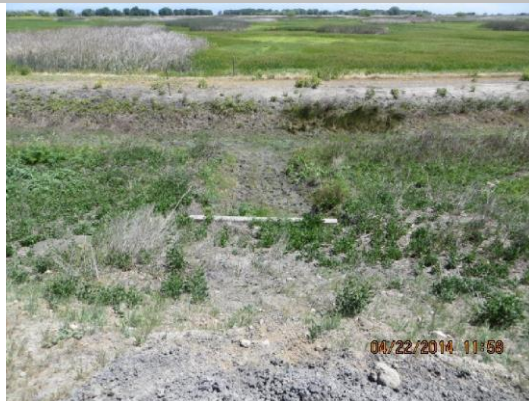
Photo 3 of 3 : UCIP\_SP\_2019\_34284\_62226.jpg

Headwall and pipe on LS toe.

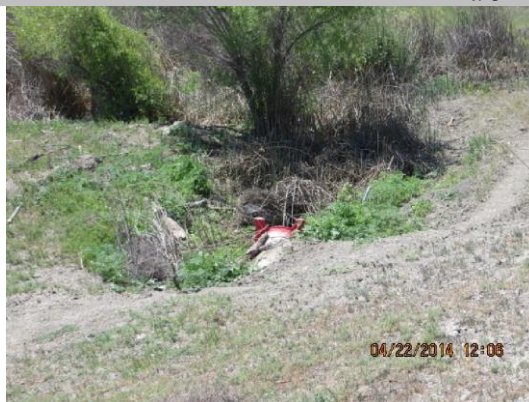
Photo 1 of 3 : UCIP\_SP\_2019\_34285\_62230.jpg

Headwall, flapgate, and pipe on WS toe.

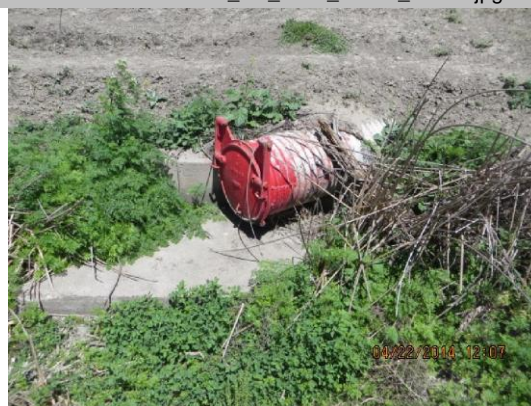
Photo 2 of 3 : UCIP\_SP\_2019\_34285\_62229.jpg

Headwall, flapgate, and pipe on WS toe.

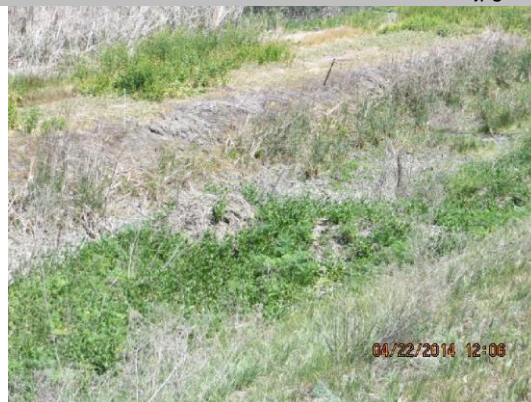
Photo 3 of 3 : UCIP\_SP\_2019\_34285\_62231.jpg

Headwall and pipe on LS toe.

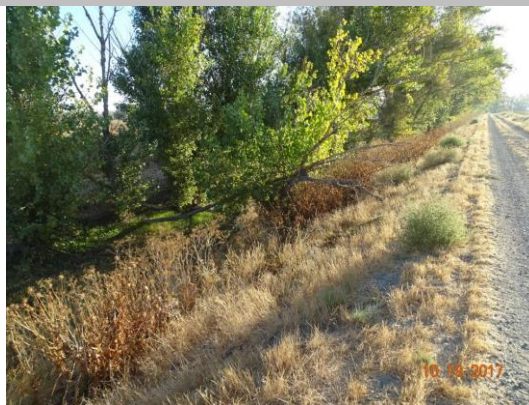
Photo 2 of 2 : SP\_2019\_NA0010\_123\_108\_20190307\_00016.jpg

Looking east at the landside slope. (Fall 2017)

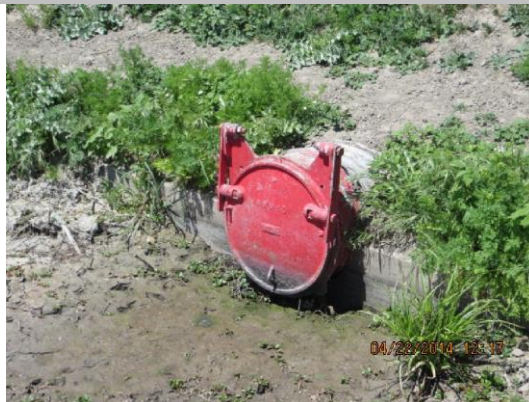
Photo 2 of 3 : UCIP\_SP\_2019\_39593\_62241.jpg

Headwall, flapgate, and pipe on WS toe.

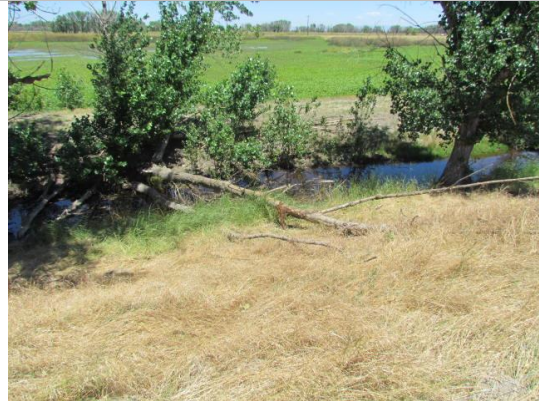
Photo 1 of 1 : SP\_2019\_NA0010\_123\_2\_20190307\_00002.jpg

LM Start	13.01	Rating **	M	Issue No.	2
LM End	13.01	Issue Type +	Ma	Location *	LS
Category	Earthen Levee			GPS Latitude/Longitude	
				Start	End
Item	Encroachments			37.175576 °	37.175576 °
				-120.638755 °	-120.638755 °
DWR ID	DWR_NA0010_05_s_2016_2				
Comment Code					
TR : Tree or limb					
Inspector Comment					
There is a downed tree on landside toe.

Looking west at down tree at landward toe.

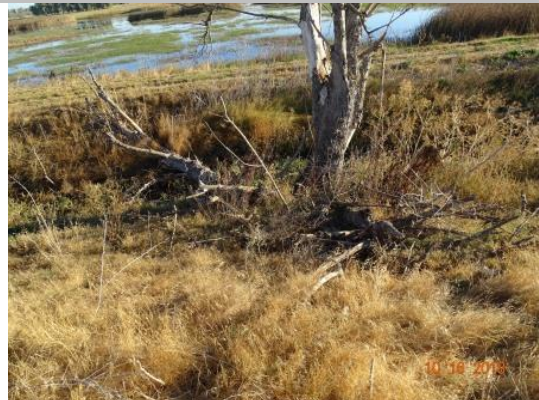
Photo 1 of 1 : SP\_2019\_NA0010\_123\_150\_20190307\_00047.jpg

LM Start	13.05	Rating **	M	Issue No.	150
LM End	13.05	Issue Type +	Ma	Location *	LS
Category	Earthen Levee			GPS Latitude/Longitude	
				Start	End
Item	Encroachments			37.175314 °	37.175314 °
				-120.638034 °	-120.638034 °
DWR ID	DWR_NA0010_05_f_2018_150				
Comment Code					
TR : Tree or limb					
Inspector Comment					
There are tree trimmings on the levee slope and toe.

Tree trimmings on landside slope and toe. (Fall 2018)

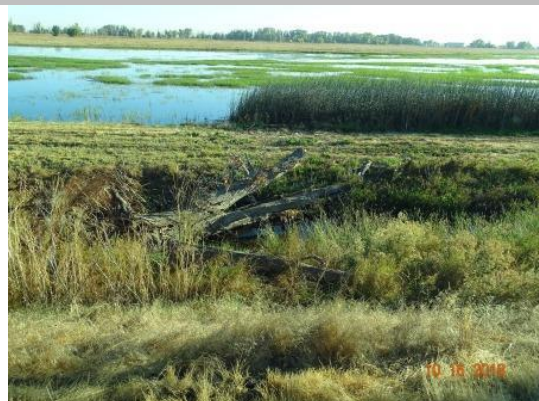
Photo 1 of 1 : SP\_2019\_NA0010\_123\_152\_20190307\_00049.jpg

LM Start	13.15	Rating **	M	Issue No.	152
LM End	13.15	Issue Type +	Ma	Location *	LS
Category	Earthen Levee			GPS Latitude/Longitude	
				Start	End
Item	Encroachments			37.174444 °	37.174444 °
				-120.636589 °	-120.636589 °
DWR ID	DWR_NA0010_05_f_2018_152				
Comment Code					
TR : Tree or limb					
Inspector Comment					
There is a tree trunk on landside toe.

Tree trunk on landside toe. (Fall 2018)

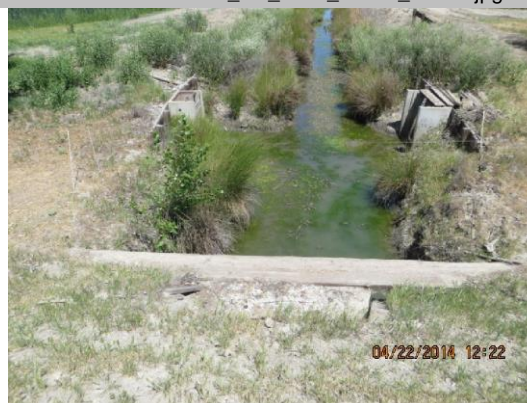
Photo 1 of 3 : UCIP\_SP\_2019\_34288\_62244.jpg

Comment Code					
Inspector Comment					
FS_ID:34288 DS_ID:19708 EP_NO: N/A Repair Type: Non-Urgent Crossing Status: Found UCIP Comments: 04/22/2014 Some erosion around headwall on the WS toe and there are animal burrows on both slopes. (DWR UCIP - W. Wylie) FIELD_STRUCT_DESC: 48-inch corrugated metal gravity drainage pipe through the levee, 10 feet below the crown. Flap gate on the waterside (WS) end. Flashboard attachment in concrete U-shaped headwall on the landside (LS) end. Concrete U-shaped headwall on the WS end. [Additional Reference(s): DWR Levee Log, 2002. USACE San Joaquin O&M Manual 601.1, 1967, (HLM 13.40)]. FS Date: 4/22/2014

Headwall and pipe on LS toe.

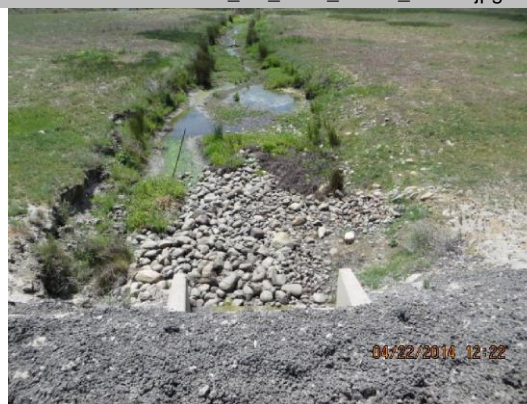
Photo 2 of 3 : UCIP\_SP\_2019\_34288\_62243.jpg

Headwall, flapgate, and pipe on WS toe.

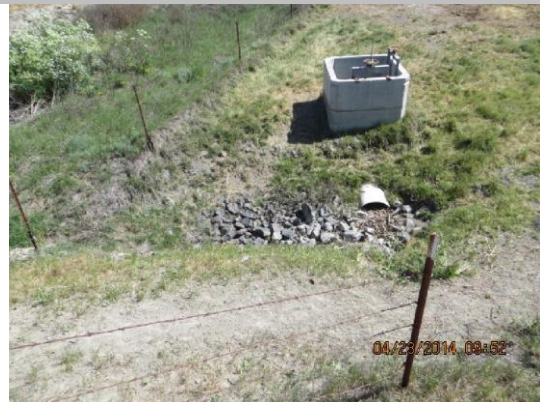
Photo 1 of 3 : UCIP\_SP\_2019\_34664\_62454.jpg

LM Start	15.11	Rating **	M	Issue No.	1343
LM End	15.11	Issue Type +	Ma	Location *	
Category	Supplemental			GPS Latitude/Longitude	
				Start	End
Item	DWR UCIP LMA Responsibility			37.156805 °	37.156805 °
				-120.609513 °	-120.609513 °
DWR ID	19712				
Comment Code					
Inspector Comment					
FS_ID:34664 DS_ID:19712 EP_NO: N/A Repair Type: Non-Urgent Crossing Status: Found UCIP Comments: 04/23/2014 Minor erosion at headwall on WS toe. (DWR UCIP - W. Wylie) FIELD_STRUCT_DESC: 36-inch corrugated metal gravity drainage pipe through the levee, 11.9 feet below the crown. Flap gate on the waterside (WS) end. Concrete headwall on each end. [Additional Reference(s): DWR Levee Log, 2002. USACE San Joaquin O&M Manual 601.1, 1967, (HLM 15.09)]. FS Date: 4/23/2014

Headwall and inlet on LS toe.

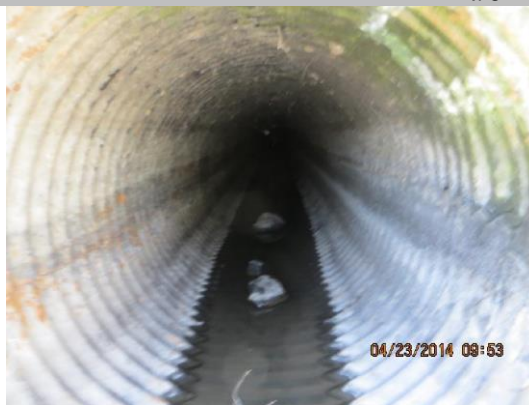
Photo 3 of 3 : UCIP\_SP\_2019\_34664\_62452.jpg

Inside pipe at LS toe.

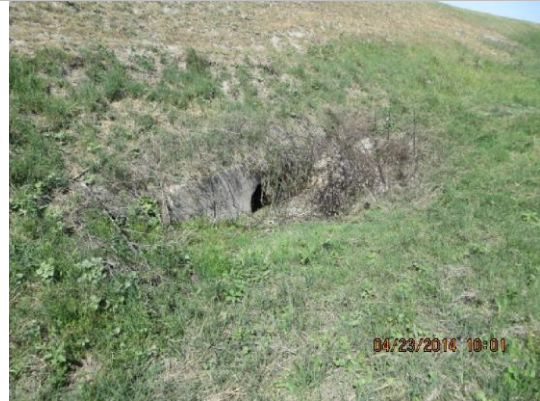
Photo 3 of 3 : UCIP\_SP\_2019\_39595\_62458.jpg

Headwall and pipe at LS toe.

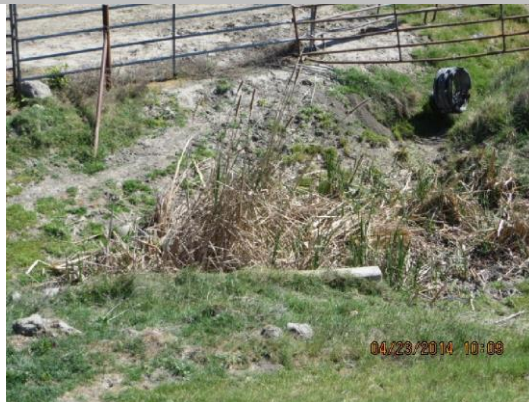
Photo 3 of 3 : UCIP\_SP\_2019\_39596\_62466.jpg

Headwall and pipe visible at LS toe.

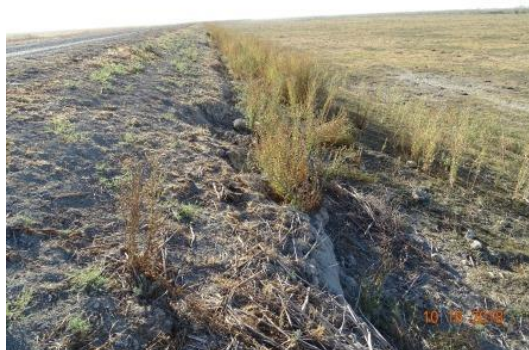
Photo 1 of 1 : SP\_2019\_NA0010\_123\_1\_20190307\_00001.jpg

LM Start	16.11	Rating **	M	Issue No.	1
LM End	16.12	Issue Type +	Ma	Location *	WS
Category	Supplemental			GPS Latitude/Longitude	
				Start	End
Item	DWR Erosion Survey			37.145965 °	37.145965 °
				-120.597597 °	-120.597597 °
DWR ID	NA0010U05RM13.85				
Comment Code					
Inspector Comment					
09/20/2017: The erosion was discovered during spring levee inspection. The site is covered by dense vegetation and the measurements of the erosion are estimated. [2017 Site ID:NA0010U05RM13.85]

View of erosion looking upstream. (Fall 2018)

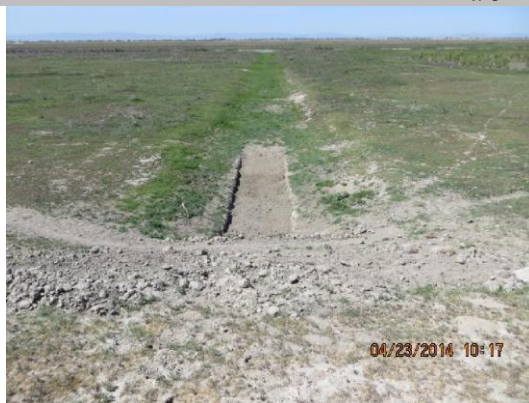
Photo 1 of 3 : UCIP\_SP\_2019\_34725\_62469.jpg

LM Start	16.68	Rating **	M	Issue No.	1346
LM End	16.68	Issue Type +	Ma	Location *	
Category	Supplemental			GPS Latitude/Longitude	
				Start	End
Item	DWR UCIP LMA Responsibility			37.138760 °	37.138760 °
				-120.592393 °	-120.592393 °
DWR ID	19716				
Comment Code					
Inspector Comment					
FS_ID:34725 DS_ID:19716 EP_NO: N/A Repair Type: Non-Urgent Crossing Status: Found UCIP Comments: 04/23/2014 Pipe heavily silted on LS toe. (DWR UCIP - W. Wylie) FIELD_STRUCT_DESC: 24-inch corrugated metal gravity drainage pipe through the levee, 10.5 feet below the crown. Flap gate on the waterside (WS) end. Concrete headwall on each end. [Additional Reference(s): DWR Levee Log, 2002. USACE San Joaquin O&M Manual 601.1, 1967, (HLM 16.67)]. FS Date: 4/23/2014

Headwall, flapgate, and pipe visible on WS toe.

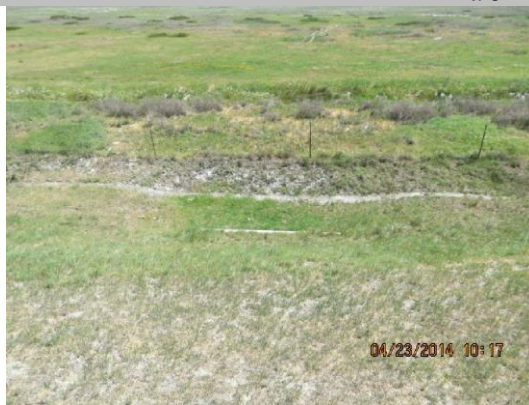
Photo 3 of 3 : UCIP\_SP\_2019\_34725\_62470.jpg

Concrete headwall and pipe visible on LS toe.

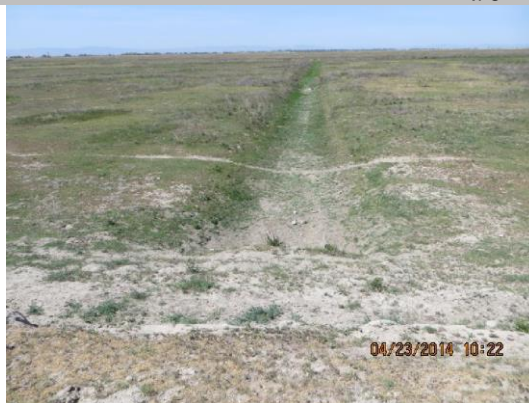
Photo 1 of 3 : UCIP\_SP\_2019\_39597\_62481.jpg

LM Start	17.22	Rating **	M	Issue No.	1347
LM End	17.22	Issue Type +	Ma	Location *	
Category	Supplemental			GPS Latitude/Longitude	
				Start	End
Item	DWR UCIP LMA Responsibility			37.132211 °	37.132211 °
				-120.587106 °	-120.587106 °
DWR ID	19717				
Comment Code					
Inspector Comment					
FS_ID:39597 DS_ID:19717 EP_NO: N/A Repair Type: Non-Urgent Crossing Status: Found UCIP Comments: 04/23/2014 Sediment buildup in pipe visible from landward side--recommend contacting owner to clear pipe. (DWR UCIP - W. Wylie) FIELD_STRUCT_DESC: 24-inch corrugated metal gravity drainage pipe through the levee, 12 feet below the crown. Flap gate on the waterside (WS) end. Concrete headwall on each end. [Additional Reference(s): DWR Levee Log, 2002. USACE San Joaquin O&M Manual 601.1, 1967, (HLM 17.20)]. FS Date: 4/23/2014

Headwall, flapgate, and pipe visible on WS toe.

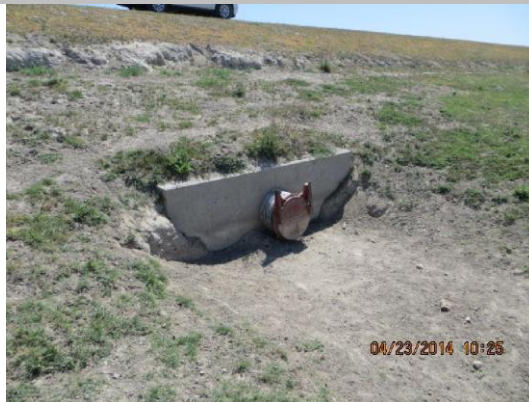
Photo 2 of 3 : UCIP\_SP\_2019\_39597\_62483.jpg

Headwall, flapgate, and pipe visible on WS toe.

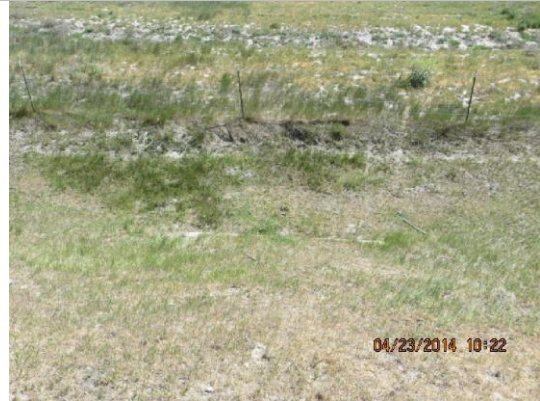
Photo 3 of 3 : UCIP\_SP\_2019\_39597\_62482.jpg

Headwall and pipe visible on LS toe.

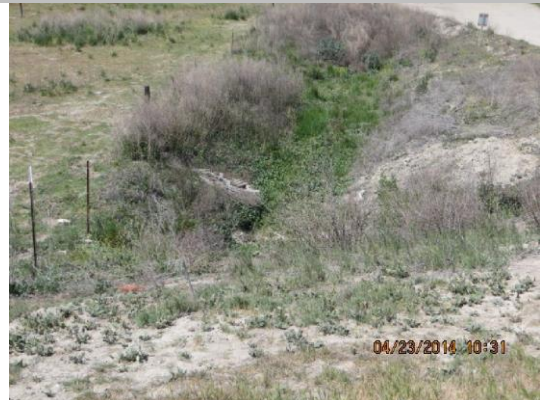
Photo 1 of 3 : UCIP\_SP\_2019\_39599\_62485.jpg

LM Start	17.54	Rating **	M	Issue No.	1348
LM End	17.54	Issue Type +	Ma	Location *	
Category	Supplemental			GPS Latitude/Longitude	
				Start	End
Item	DWR UCIP LMA Responsibility			37.127843 °	37.127843 °
				-120.585245 °	-120.585245 °
DWR ID	19743				
Comment Code					
Inspector Comment					
FS_ID:39599 DS_ID:19743 EP_NO: N/A Repair Type: Non-Urgent Crossing Status: Found UCIP Comments: 04/23/2014 Sediment buildup in pipe visible from landward side--recommend contacting owner to clear pipe. (DWR UCIP - W. Wylie) FIELD_STRUCT_DESC: 24-inch corrugated metal gravity drainage pipe through the levee, 9.8 feet below the crown. Flap gate on the waterside (WS) end. Concrete headwall on each end. [Additional Reference(s): DWR Levee Log, 2002. USACE San Joaquin O&M Manual 601.1, 1967, (HLM 17.52)]. FS Date: 4/23/2014

Headwall, pipe, and flapgate visible on WS toe.

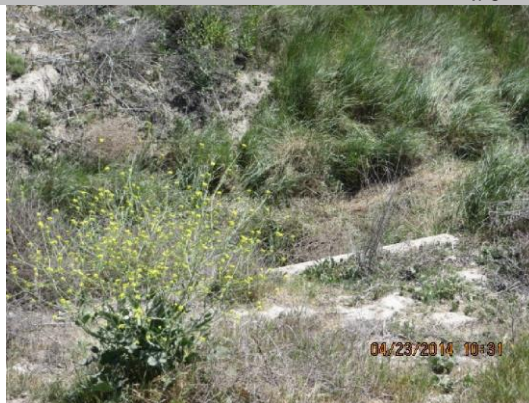
Photo 2 of 3 : UCIP\_SP\_2019\_39599\_62486.jpg

Pipe and headwall visible on LS toe.

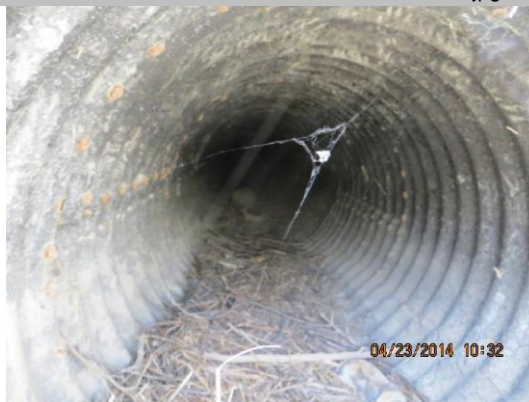
Photo 3 of 3 : UCIP\_SP\_2019\_39599\_62488.jpg

Inside pipe on LS toe.

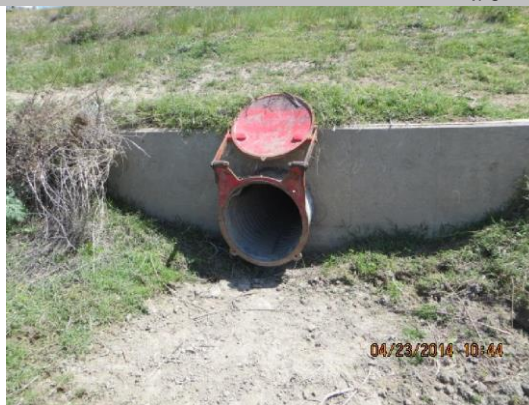
Photo 2 of 3 : UCIP\_SP\_2019\_34747\_62495.jpg

Headwall, pipe, and flapgate on WS toe.

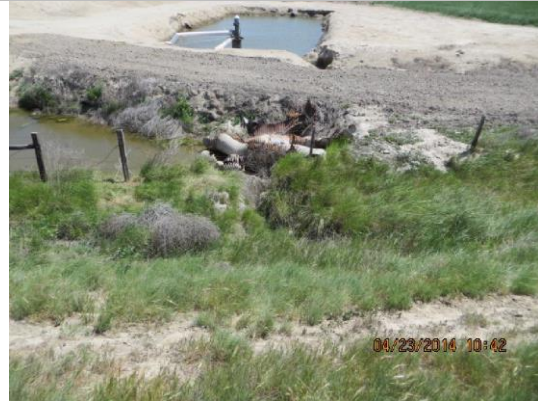
Photo 3 of 3 : UCIP\_SP\_2019\_34747\_62493.jpg

LM Start	18.09	Rating **	M	Issue No.	1349 (cont)
LM End	18.09	Issue Type +	Ma	Location *	
Category	Supplemental			GPS Latitude/Longitude	
				Start	End
Item	DWR UCIP LMA Responsibility			37.120309 °	37.120309 °
				-120.582041 °	-120.582041 °
DWR ID	19745				
Comment Code					
Inspector Comment					
FS_ID:34747 DS_ID:19745 EP_NO: N/A Repair Type: Non-Urgent Crossing Status: Found UCIP Comments: 04/23/2014 Animal burrows in levee on both slopes. (DWR UCIP - W. Wylie) FIELD_STRUCT_DESC: 24-inch corrugated metal gravity drainage pipe through the levee, 12.4 feet below the crown. Flap gate on the waterside (WS) end. Concrete headwall on each end. [Additional Reference(s): DWR Levee Log, 2002. USACE San Joaquin O&M Manual 601.1, 1967, (HLM 18.07)]. FS Date: 4/23/2014

Headwall and pipe visible on LS toe.

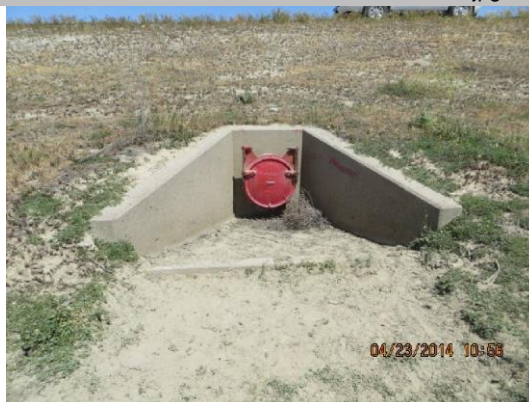
Photo 2 of 3 : UCIP\_SP\_2019\_39601\_62506.jpg

Headwall, pipe, and flapgate visible on WS toe.

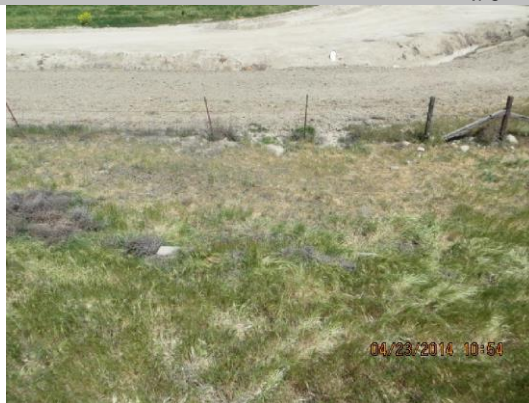
Photo 3 of 3 : UCIP\_SP\_2019\_39601\_62505.jpg

LM Start	19.15	Rating **	M	Issue No.	1351 (cont)	
LM End	19.15	Issue Type +	Ma	Location *		
Category	Supplemental			GPS Latitude/Longitude		
				Start		End
Item	DWR UCIP LMA Responsibility			37.115466 °		37.115466 °
				-120.565467 °		-120.565467 °
DWR ID	19747					
Comment Code						
Inspector Comment						
FS_ID:39601 DS_ID:19747 EP_NO: N/A Repair Type: Non-Urgent Crossing Status: Found UCIP Comments: 04/23/2014 Sediment buildup in pipe visible from landward side--recommend contacting owner to clear pipe. (DWR UCIP - W. Wylie) FIELD_STRUCT_DESC: 24-inch corrugated metal gravity drainage pipe through the levee, 10 feet below the crown. Flap gate on the waterside (WS) end. Concrete headwall on the landside (LS) end. Concrete U-shaped headwall on the WS end. [Additional Reference(s): DWR Levee Log, 2002. USACE San Joaquin O&M Manual 601.1, 1967, (HLM 19.11)]. FS Date: 4/23/2014

Headwall and pipe visible on LS toe.

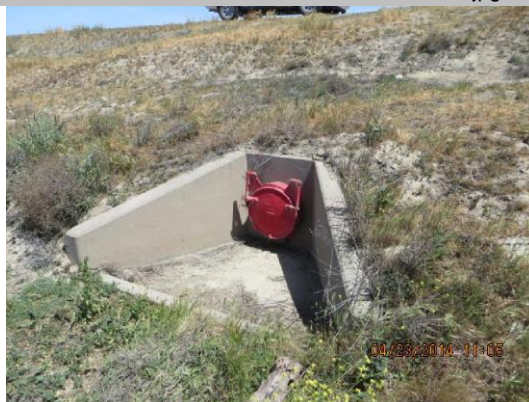
Photo 2 of 3 : UCIP\_SP\_2019\_39602\_62516.jpg

Headwall, pipe, and flapgate visible on WS toe.

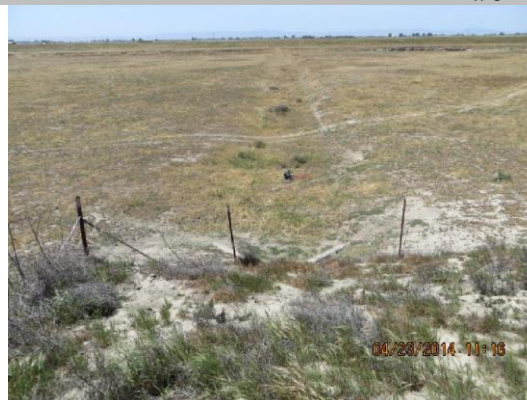
Photo 1 of 3 : UCIP\_SP\_2019\_39603\_62519.jpg

Comment Code					
Inspector Comment					
FS_ID:39603 DS_ID:19778 EP_NO: N/A Repair Type: Non-Urgent Crossing Status: Found UCIP Comments: 04/23/2014 Dense vegetation limits the inspector's visibility to identify signs of pipe failure (leaks) along the landward slope. Recommend removing vegetation along pipe alignment to conduct proper inspection of structure. Sediment buildup in pipe visible from landward side--recommend contacting owner to clear pipe. (DWR UCIP - W. Wylie) FIELD_STRUCT_DESC: 24-inch corrugated metal gravity drainage pipe through the levee, 9.7 feet below the crown. Flap gate on the waterside (WS) end. Concrete headwall on the landside (LS) end. Concrete U-shaped headwall on the WS end. [Additional Reference(s): DWR Levee Log, 2002. USACE San Joaquin O&M Manual 601.1, 1967, (HLM 19.50)]. FS Date: 4/23/2014

Headwall, pipe, and flapgate visible on WS toe.

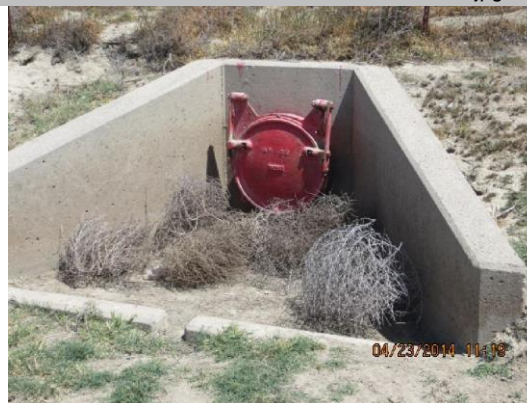
Photo 2 of 3 : UCIP\_SP\_2019\_39603\_62521.jpg

Headwall, pipe, and flapgate visible on WS toe.

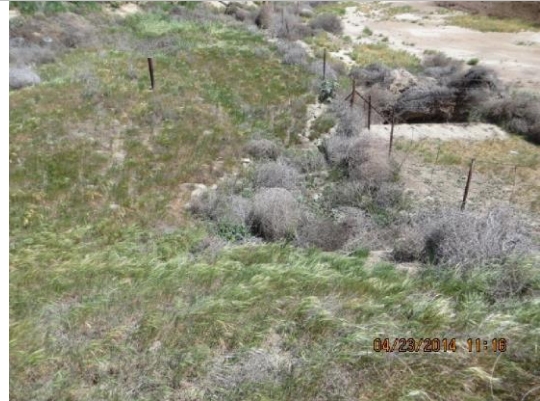
Photo 3 of 3 : UCIP\_SP\_2019\_39603\_62520.jpg

Comment Code					
Inspector Comment					
FS_ID:39603 DS_ID:19778 EP_NO: N/A Repair Type: Non-Urgent Crossing Status: Found UCIP Comments: 04/23/2014 Dense vegetation limits the inspector's visibility to identify signs of pipe failure (leaks) along the landward slope. Recommend removing vegetation along pipe alignment to conduct proper inspection of structure. Sediment buildup in pipe visible from landward side--recommend contacting owner to clear pipe. (DWR UCIP - W. Wylie) FIELD_STRUCT_DESC: 24-inch corrugated metal gravity drainage pipe through the levee, 9.7 feet below the crown. Flap gate on the waterside (WS) end. Concrete headwall on the landside (LS) end. Concrete U-shaped headwall on the WS end. [Additional Reference(s): DWR Levee Log, 2002. USACE San Joaquin O&M Manual 601.1, 1967, (HLM 19.50)]. FS Date: 4/23/2014

Headwall and pipe visible on LS toe.

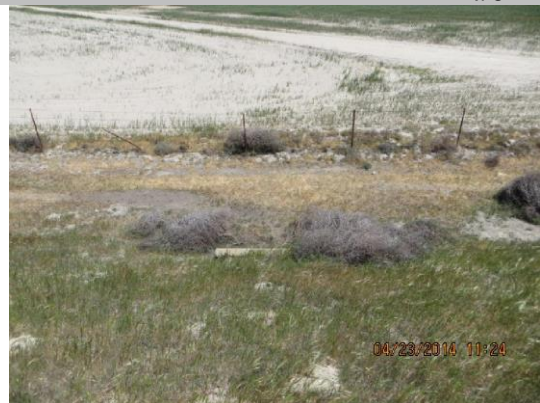
Photo 1 of 3 : UCIP\_SP\_2019\_34754\_62525.jpg

LM Start	19.86	Rating **	A/W	Issue No.	1356
LM End	19.86	Issue Type +	Ma	Location *	
Category	Supplemental			GPS Latitude/Longitude	
				Start	End
Item	DWR UCIP LMA Responsibility			37.109284 °	37.109284 °
				-120.555948 °	-120.555948 °
DWR ID	19779				
Comment Code					
Inspector Comment					
FS_ID:34754 DS_ID:19779 EP_NO: N/A Repair Type: No Action Needed Crossing Status: Found UCIP Comments: FIELD_STRUCT_DESC: 24-inch corrugated metal gravity drainage pipe through the levee, 10.3 feet below the crown. Flap gate on the waterside (WS) end. Concrete headwall on the landside (LS) end. Concrete U-shaped headwall on the WS end. [Additional Reference(s): DWR Levee Log, 2002. USACE San Joaquin O&M Manual 601.1, 1967, (HLM 19.84)]. FS Date: 4/23/2014

Headwall and pipe visible on LS toe.

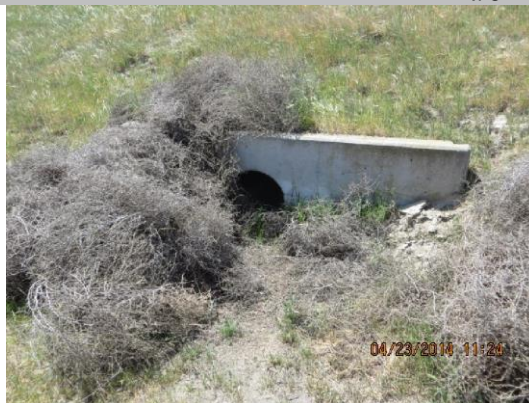
Photo 2 of 3 : UCIP\_SP\_2019\_34754\_62524.jpg

LM Start	19.86	Rating **	A/W	Issue No.	1356 (cont)	
LM End	19.86	Issue Type +	Ma	Location *		
Category	Supplemental			GPS Latitude/Longitude		
				Start	End	
Item	DWR UCIP LMA Responsibility			37.109284 °	37.109284 °	
				-120.555948 °	-120.555948 °	
DWR ID	19779					
Comment Code						
Inspector Comment						
FS_ID:34754 DS_ID:19779 EP_NO: N/A Repair Type: No Action Needed Crossing Status: Found UCIP Comments: FIELD_STRUCT_DESC: 24-inch corrugated metal gravity drainage pipe through the levee, 10.3 feet below the crown. Flap gate on the waterside (WS) end. Concrete headwall on the landside (LS) end. Concrete U-shaped headwall on the WS end. [Additional Reference(s): DWR Levee Log, 2002. USACE San Joaquin O&M Manual 601.1, 1967, (HLM 19.84)]. FS Date: 4/23/2014

Headwall and pipe visible on LS toe.

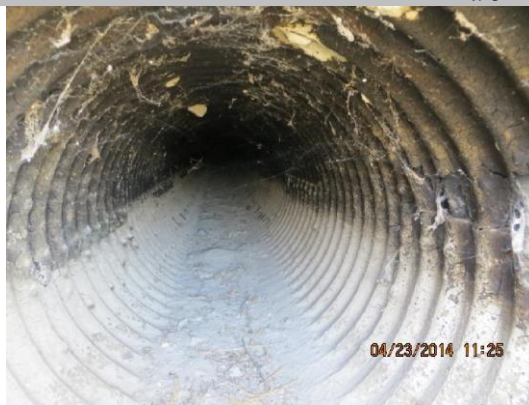
Photo 3 of 3 : UCIP\_SP\_2019\_34754\_62523.jpg

Inside pipe on LS toe.

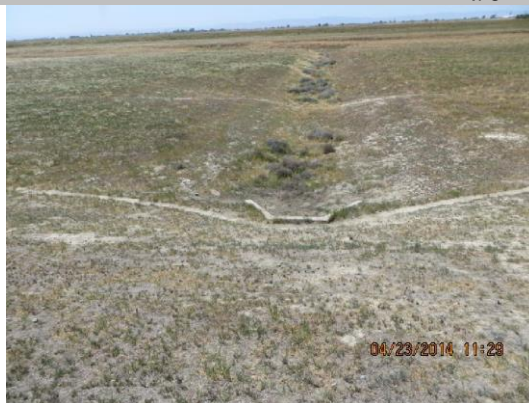
Photo 1 of 3 : UCIP\_SP\_2019\_34755\_62529.jpg

LM Start	19.94	Rating **	A/W	Issue No.	1357
LM End	19.94	Issue Type +	Ma	Location *	
Category	Supplemental			GPS Latitude/Longitude	
				Start	End
Item	DWR UCIP LMA Responsibility			37.108426 °	37.108426 °
				-120.554990 °	-120.554990 °
DWR ID	19780				
Comment Code					
Inspector Comment					
FS_ID:34755 DS_ID:19780 EP_NO: N/A Repair Type: No Action Needed Crossing Status: Found UCIP Comments: FIELD_STRUCT_DESC: 36-inch corrugated metal gravity drainage pipe through the levee, 9.8 feet below the crown. Flap gate on the waterside (WS) end. Concrete headwall on the landside (LS) end. Concrete U-shaped headwall on the WS end. [Additional Reference(s): DWR Levee Log, 2002. USACE San Joaquin O&M Manual 601.1, 1967, (HLM 19.92)]. FS Date: 4/23/2014

Headwall, pipe, and flapgate visible on WS toe.

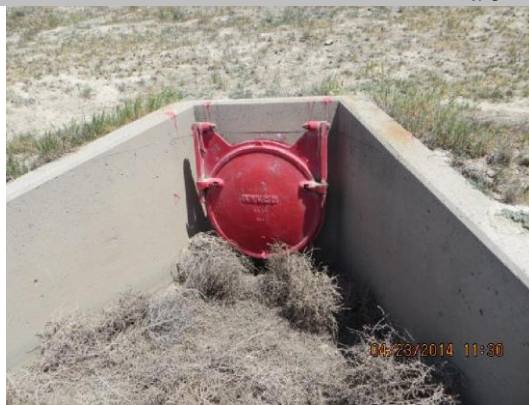
Photo 2 of 3 : UCIP\_SP\_2019\_34755\_62530.jpg

Headwall, pipe, and flapgate visible on WS toe.

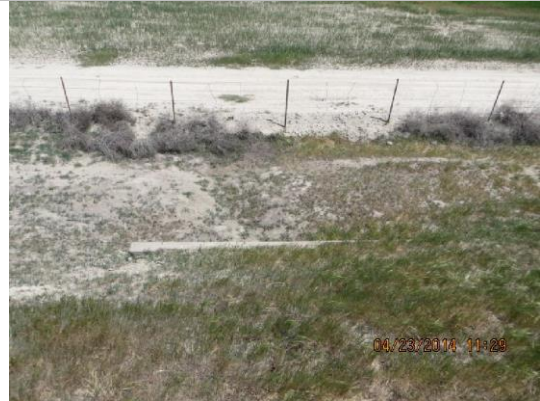
Photo 3 of 3 : UCIP\_SP\_2019\_34755\_62528.jpg

LM Start	19.94	Rating **	A/W	Issue No.	1357 (cont)	
LM End	19.94	Issue Type +	Ma	Location *		
Category	Supplemental			GPS Latitude/Longitude		
				Start	End	
Item	DWR UCIP LMA Responsibility			37.108426 °	37.108426 °	
				-120.554990 °	-120.554990 °	
DWR ID	19780					
Comment Code						
Inspector Comment						
FS_ID:34755 DS_ID:19780 EP_NO: N/A Repair Type: No Action Needed Crossing Status: Found UCIP Comments: FIELD_STRUCT_DESC: 36-inch corrugated metal gravity drainage pipe through the levee, 9.8 feet below the crown. Flap gate on the waterside (WS) end. Concrete headwall on the landside (LS) end. Concrete U-shaped headwall on the WS end. [Additional Reference(s): DWR Levee Log, 2002. USACE San Joaquin O&M Manual 601.1, 1967, (HLM 19.92)]. FS Date: 4/23/2014

Headwall and pipe visible on LS toe.

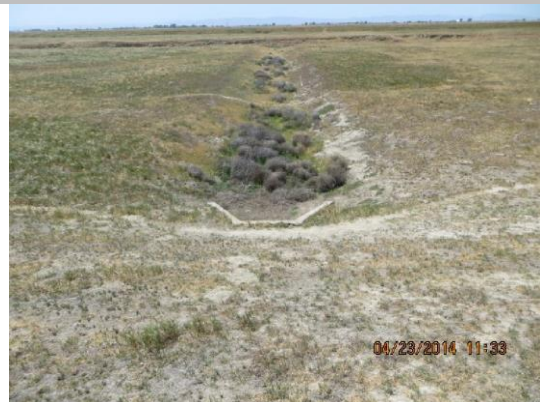
Photo 1 of 3 : UCIP\_SP\_2019\_34757\_62533.jpg

LM Start	20.10	Rating **	A/W	Issue No.	1358
LM End	20.10	Issue Type +	Ma	Location *	
Category	Supplemental			GPS Latitude/Longitude	
				Start	End
Item	DWR UCIP LMA Responsibility			37.107091 °	37.107091 °
				-120.553503 °	-120.553503 °
DWR ID	19781				
Comment Code					
Inspector Comment					
FS_ID:34757 DS_ID:19781 EP_NO: N/A Repair Type: No Action Needed Crossing Status: Found UCIP Comments: FIELD_STRUCT_DESC: 36-inch corrugated metal gravity drainage pipe through the levee, 9.9 feet below the crown. Flap gate on the waterside (WS) end. Concrete headwall on the landside (LS) end. Concrete U-shaped headwall on the WS end. [Additional Reference(s): DWR Levee Log, 2002. USACE San Joaquin O&M Manual 601.1, 1967, (HLM 20.05)]. FS Date: 4/23/2014

Headwall, pipe, and flapgate visible on WS toe.

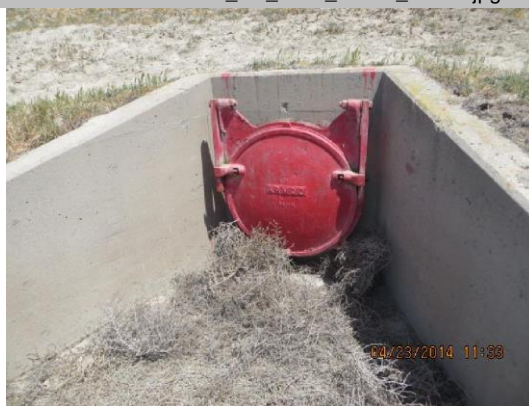
Photo 2 of 3 : UCIP\_SP\_2019\_34757\_62532.jpg

LM Start	20.10	Rating **	A/W	Issue No.	1358 (cont)
LM End	20.10	Issue Type +	Ma	Location *	
Category	Supplemental			GPS Latitude/Longitude	
				Start	End
Item	DWR UCIP LMA Responsibility			37.107091 °	37.107091 °
				-120.553503 °	-120.553503 °
DWR ID	19781				
Comment Code					
Inspector Comment					
FS_ID:34757 DS_ID:19781 EP_NO: N/A Repair Type: No Action Needed Crossing Status: Found UCIP Comments: FIELD_STRUCT_DESC: 36-inch corrugated metal gravity drainage pipe through the levee, 9.9 feet below the crown. Flap gate on the waterside (WS) end. Concrete headwall on the landside (LS) end. Concrete U-shaped headwall on the WS end. [Additional Reference(s): DWR Levee Log, 2002. USACE San Joaquin O&M Manual 601.1, 1967, (HLM 20.05)]. FS Date: 4/23/2014

Headwall, pipe, and flapgate visible on WS toe.

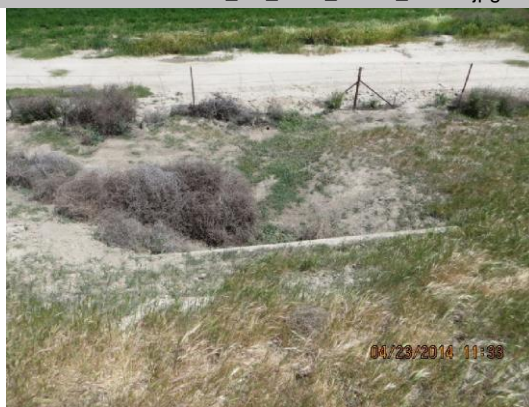
Photo 3 of 3 : UCIP\_SP\_2019\_34757\_62534.jpg

Headwall and pipe visible on LS toe.

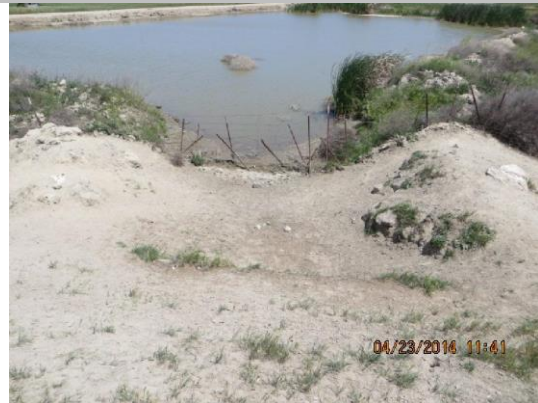
Photo 3 of 3 : UCIP\_SP\_2019\_34760\_62540.jpg

LM Start	20.24	Rating **	A/W	Issue No.	1360 (cont)	
LM End	20.24	Issue Type +	Ma	Location *		
Category	Supplemental			GPS Latitude/Longitude		
				Start		End
Item	DWR UCIP LMA Responsibility			37.105489 °		37.105489 °
				-120.551886 °		-120.551886 °
DWR ID	19783					
Comment Code						
Inspector Comment						
FS_ID:34760 DS_ID:19783 EP_NO: N/A Repair Type: No Action Needed Crossing Status: Found UCIP Comments: FIELD_STRUCT_DESC: 36-inch corrugated metal gravity drainage pipe through the levee, 10.6 feet below the crown. Flap gate on the waterside (WS) end. Concrete headwall on each end. [Additional Reference(s): DWR Levee Log, 2002. USACE San Joaquin O&M Manual 601.1, 1967, (HLM 20.18)]. FS Date: 4/23/2014

Headwall and pipe visible on LS toe.

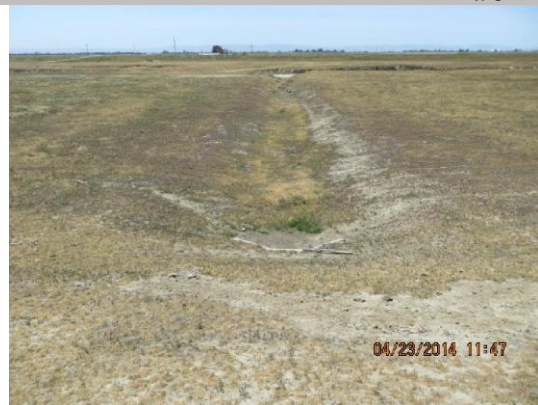
Photo 1 of 3 : UCIP\_SP\_2019\_39605\_62544.jpg

Comment Code					
Inspector Comment					
FS_ID:39605 DS_ID:19784 EP_NO: N/A Repair Type: Non-Urgent Crossing Status: Found UCIP Comments: 04/23/2014 Dense vegetation limits the inspector's visibility to identify signs of pipe failure (leaks) along the landward slope. Recommend removing vegetation along pipe alignment to conduct proper inspection of structure. (DWR UCIP - W. Wylie) FIELD_STRUCT_DESC: 24-inch corrugated metal gravity drainage pipe through the levee, 10.5 feet below the crown. Flap gate on the waterside (WS) end. Concrete headwall on the landside (LS) end. Concrete U-shaped headwall on the WS end. [Additional Reference(s): DWR Levee Log, 2002. USACE San Joaquin O&M Manual 601.1, 1967, (HLM 20.59)]. FS Date: 4/23/2014

Headwall, pipe, and flapgate visible on WS toe.
