**Flood Control Project Maintenance  
Levee Inspections**

## Maintenance Issue Types Only, Levee Inspection Report By Mile - Spring 2019

### Lower San Joaquin Levee District

Waterway	Bank	Unit Miles	Inspection Start/End	Inspector
Unit No. 01 San Joaquin River	Right	22.52	03/26/2019 03/26/2019	Corey Fujitani

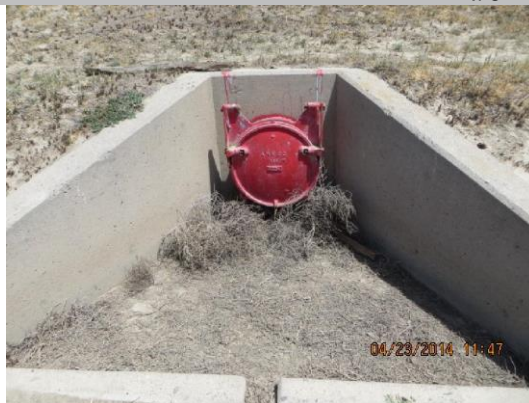
Photo 2 of 3 : UCIP\_SP\_2019\_39605\_62543.jpg

Item	DWR UCIP LMA Responsibility			37.100903 °	37.100903 °	
				-120.547282 °	-120.547282 °	
DWR ID	19784					
Comment Code						
Inspector Comment						
FS_ID:39605						
DS_ID:19784						
EP_NO: N/A						
Repair Type: Non-Urgent						
Crossing Status: Found						
UCIP Comments: 04/23/2014 Dense vegetation limits the inspector's visibility to identify signs of pipe failure (leaks) along the landward slope. Recommend removing vegetation along pipe alignment to conduct proper inspection of structure. (DWR UCIP - W. Wylie)						
FIELD_STRUCT_DESC: 24-inch corrugated metal gravity drainage pipe through the levee, 10.5 feet below the crown. Flap gate on the waterside (WS) end. Concrete headwall on the landside (LS) end. Concrete U-shaped headwall on the WS end. [Additional Reference(s): DWR Levee Log, 2002. USACE San Joaquin O&M Manual 601.1, 1967, (HLM 20.59)].						
FS Date: 4/23/2014

Headwall, pipe, and flapgate visible on WS toe.

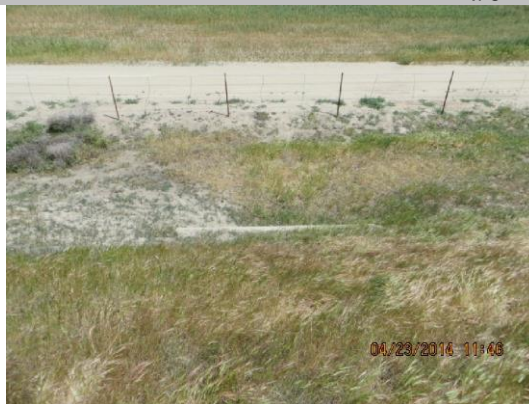
Photo 3 of 3 : UCIP\_SP\_2019\_39605\_62545.jpg

Headwall and pipe visible on LS toe.

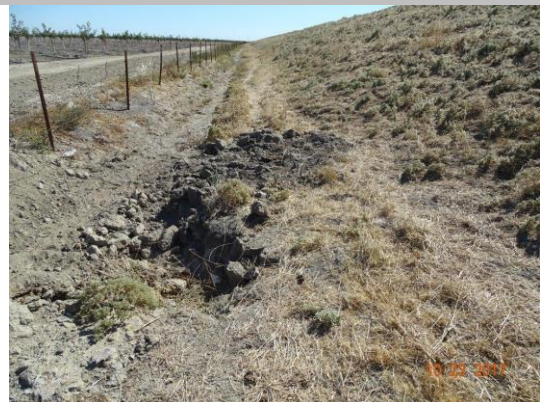
Photo 1 of 1 : SP\_2019\_NA0010\_123\_120\_20190307\_00022.jpg

LM Start	21.45	Rating **	M	Issue No.	120
LM End	21.45	Issue Type +	Ma	Location *	LS
Category	Earthen Levee			GPS Latitude/Longitude	
				Start	End
Item	Erosion / Bank Caving			37.092064 °	37.092064 °
				-120.537750 °	-120.537750 °
DWR ID	DWR_NA0010_05_f_2017_120				
Comment Code					
E2 : Schedule repair of erosion site prior to the next inspection.					
Inspector Comment					
Repair holes dug at the landside toe.

Looking southeast at the landside toe.

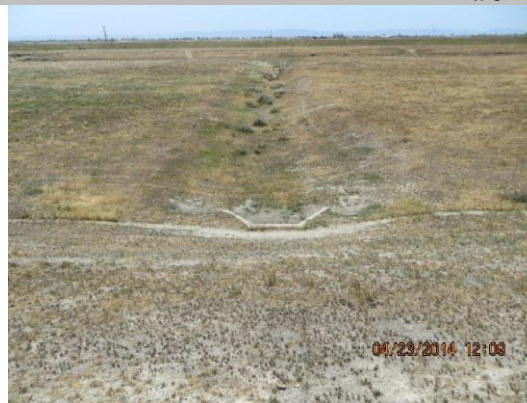
Photo 1 of 3 : UCIP\_SP\_2019\_39614\_62555.jpg

Comment Code					
Inspector Comment					
FS_ID:39614 DS_ID:19786 EP_NO: N/A Repair Type: Non-Urgent Crossing Status: Found UCIP Comments: 04/23/2014 Dense vegetation limits the inspector's visibility to identify signs of pipe failure (leaks) along the landward slope. Recommend removing vegetation along pipe alignment to conduct proper inspection of structure. (DWR UCIP - W. Wylie) FIELD_STRUCT_DESC: 36-inch corrugated metal gravity drainage pipe through the levee, 12.7 feet below the crown. Flap gate on the waterside (WS) end. Concrete headwall on the landside (LS) end. Concrete U-shaped headwall on the WS end. [Additional Reference(s): DWR Levee Log, 2002. USACE San Joaquin O&M Manual 601.1, 1967, (HLM 21.42)]. FS Date: 4/23/2014

Headwall, pipe, and flapgate visible on WS toe.

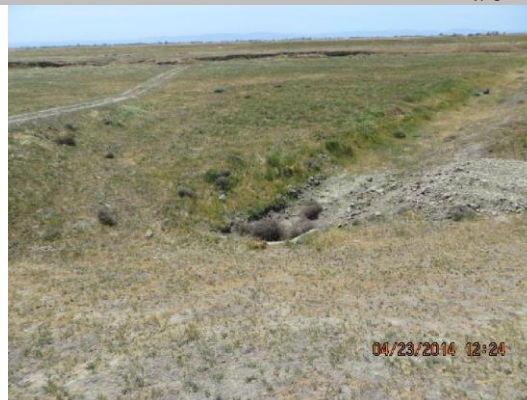
Photo 1 of 3 : UCIP\_SP\_2019\_39883\_62559.jpg

Comment Code					
Inspector Comment					
FS_ID:39883 DS_ID:19787 EP_NO: N/A Repair Type: Non-Urgent Crossing Status: Found UCIP Comments: 04/23/2014 Dense vegetation limits the inspector's visibility to identify signs of pipe failure (leaks) along the landward slope. Recommend removing vegetation along pipe alignment to conduct proper inspection of structure. (DWR UCIP - W. Wylie) FIELD_STRUCT_DESC: 24-inch corrugated metal gravity drainage pipe through the levee, 12.4 feet below the crown. Flap gate on the waterside (WS) end. Concrete headwall on the landside (LS) end. Concrete U-shaped headwall on the WS end. [Additional Reference(s): DWR Levee Log, 2002. USACE San Joaquin O&M Manual 601.1, 1967, (HLM 21.81)]. FS Date: 4/23/2014

Headwall, pipe, and flapgate visible on WS toe.

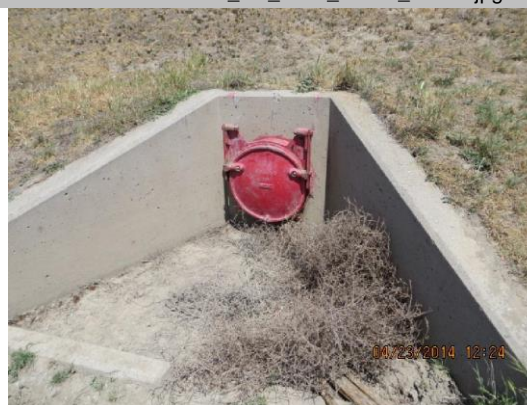
Photo 2 of 3 : UCIP\_SP\_2019\_39883\_62558.jpg

Headwall, pipe, and flapgate visible on WS toe.

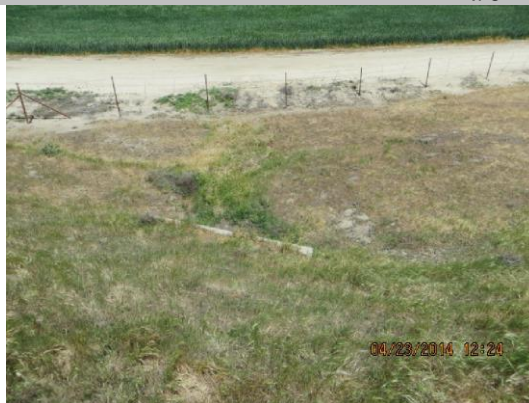
Photo 3 of 3 : UCIP\_SP\_2019\_39883\_62560.jpg

Item	DWR UCIP LMA Responsibility			37.087525 °	37.087525 °	
				-120.532827 °	-120.532827 °	
DWR ID	19787					
Comment Code						
Inspector Comment						
FS_ID:39883						
DS_ID:19787						
EP_NO: N/A						
Repair Type: Non-Urgent						
Crossing Status: Found						
UCIP Comments: 04/23/2014 Dense vegetation limits the inspector's visibility to identify signs of pipe failure (leaks) along the landward slope. Recommend removing vegetation along pipe alignment to conduct proper inspection of structure. (DWR UCIP - W. Wylie)						
FIELD_STRUCT_DESC: 24-inch corrugated metal gravity drainage pipe through the levee, 12.4 feet below the crown. Flap gate on the waterside (WS) end. Concrete headwall on the landside (LS) end. Concrete U-shaped headwall on the WS end. [Additional Reference(s): DWR Levee Log, 2002. USACE San Joaquin O&M Manual 601.1, 1967, (HLM 21.81)].						
FS Date: 4/23/2014

Headwall and pipe visible on LS toe.

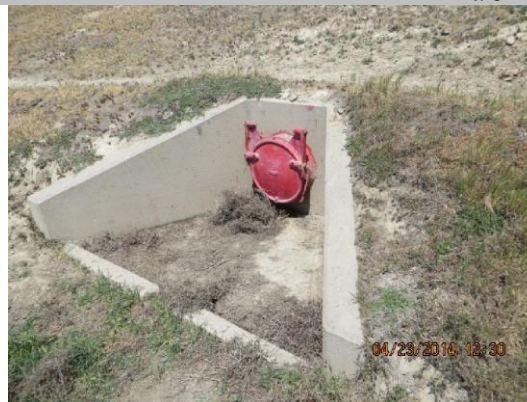
Photo 2 of 3 : UCIP\_SP\_2019\_39610\_62588.jpg

Headwall, pipe, and flapgate visible on WS toe.

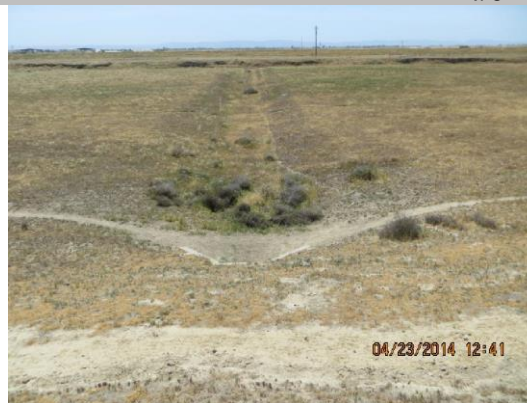
Photo 1 of 3 : UCIP\_SP\_2019\_39611\_62591.jpg

Comment Code						
Inspector Comment						
FS_ID:39611 DS_ID:19789 EP_NO: N/A Repair Type: Non-Urgent Crossing Status: Found UCIP Comments: 04/23/2014 Dense vegetation limits the inspector's visibility to identify signs of pipe failure (leaks) along the landward slope. Recommend removing vegetation along pipe alignment to conduct proper inspection of structure. Sediment buildup in pipe visible from landward side--recommend contacting owner to clear pipe. (DWR UCIP - W. Wylie) FIELD_STRUCT_DESC: 24-inch corrugated metal gravity drainage pipe through the levee, 10.2 feet below the crown. Flap gate on the waterside (WS) end. Concrete headwall on the landside (LS) end. Concrete U-shaped headwall on the WS end. [Additional Reference(s): DWR Levee Log, 2002. USACE San Joaquin O&M Manual 601.1, 1967, (HLM 22.19)]. FS Date: 4/23/2014

Headwall, pipe, and flapgate visible on WS toe.

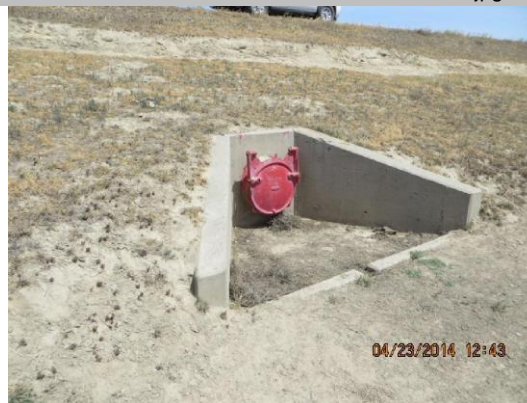
Photo 2 of 3 : UCIP\_SP\_2019\_39611\_62593.jpg

Headwall, pipe, and flapgate visible on WS toe.

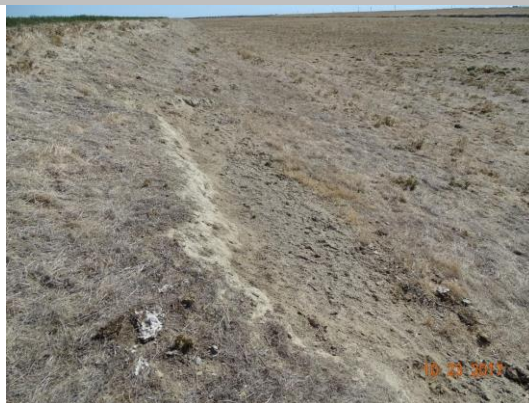
Photo 1 of 1 : SP\_2019\_NA0010\_123\_121\_20190307\_00023.jpg

LM Start	22.35	Rating **	M	Issue No.	121
LM End	22.35	Issue Type +	Ma	Location *	WS
Category	Earthen Levee			GPS Latitude/Longitude	
				Start	End
Item	Erosion / Bank Caving			37.082696 °	37.082696 °
				-120.527620 °	-120.527620 °
DWR ID	DWR_NA0010_05_f_2017_121				
Comment Code					
E1 : Note and monitor erosion site.					
Inspector Comment					
Waterside slope damaged by animal traffic.

Looking southeast at the waterside slope.

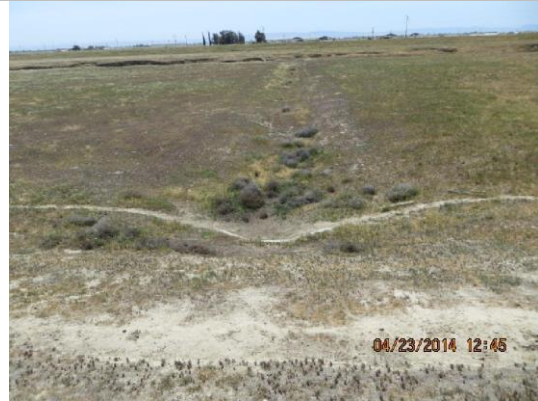
Photo 1 of 3 : UCIP\_SP\_2019\_39613\_62596.jpg

Comment Code					
Inspector Comment					
FS_ID:39613 DS_ID:19790 EP_NO: N/A Repair Type: Non-Urgent Crossing Status: Found UCIP Comments: 04/23/2014 Dense vegetation limits the inspector's visibility to identify signs of pipe failure (leaks) along the landward slope. Recommend removing vegetation along pipe alignment to conduct proper inspection of structure. Sediment buildup in pipe visible from landward side--recommend contacting owner to clear pipe. (DWR UCIP - W. Wylie) FIELD_STRUCT_DESC: 24-inch corrugated metal gravity drainage pipe through the levee, 10.4 feet below the crown. Flap gate on the waterside (WS) end. Concrete headwall on the landside (LS) end. Concrete U-shaped headwall on the WS end. [Additional Reference(s): DWR Levee Log, 2002. USACE San Joaquin O&M Manual 601.1, 1967, (HLM 22.46)]. FS Date: 4/23/2014

Headwall, pipe, and flapgate visible on WS toe.

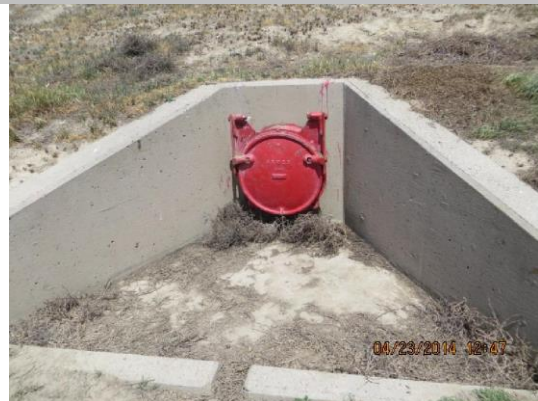
Photo 2 of 3 : UCIP\_SP\_2019\_39613\_62598.jpg

Headwall, pipe, and flapgate visible on WS toe.

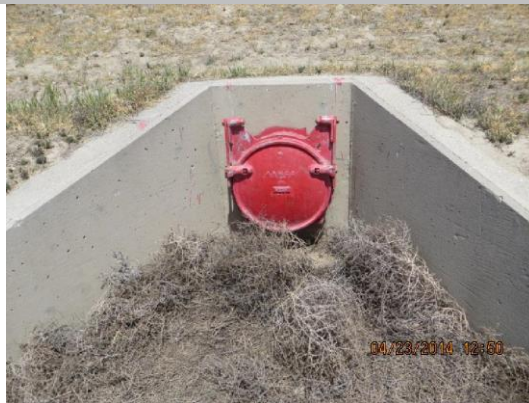
Photo 2 of 3 : UCIP\_SP\_2019\_39616\_62600.jpg

Headwall, pipe, and flapgate visible on WS toe.

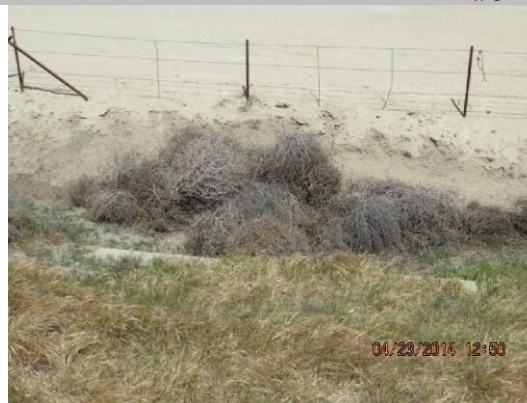
Photo 3 of 3 : UCIP\_SP\_2019\_39616\_62602.jpg

Item	DWR UCIP LMA Responsibility			37.076830 °	37.076830 °	
				-120.521116 °	-120.521116 °	
DWR ID	19791					
Comment Code						
Inspector Comment						
FS_ID:39616 DS_ID:19791 EP_NO: N/A Repair Type: Non-Urgent Crossing Status: Found UCIP Comments: 04/23/2014 Dense vegetation limits the inspector's visibility to identify signs of pipe failure (leaks) along the landward slope. Recommend removing vegetation along pipe alignment to conduct proper inspection of structure. Sediment buildup in pipe visible from landward side--recommend contacting owner to clear pipe. (DWR UCIP - W. Wylie) FIELD_STRUCT_DESC: 24-inch corrugated metal gravity drainage pipe through the levee, 12.2 feet below the crown. Flap gate on the waterside (WS) end. Concrete headwall on the landside (LS) end. Concrete U-shaped headwall on the WS end. [Additional Reference(s): DWR Levee Log, 2002. USACE San Joaquin O&M Manual 601.1, 1967, (HLM 22.79)]. FS Date: 4/23/2014

Headwall and pipe visible on LS toe.

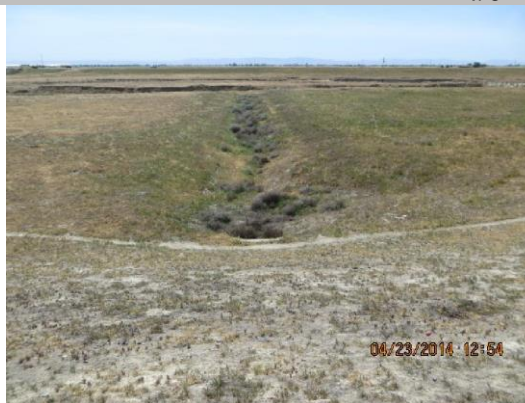
Photo 1 of 3 : UCIP\_SP\_2019\_39617\_62606.jpg

Comment Code						
Inspector Comment						
FS_ID:39617 DS_ID:19792 EP_NO: N/A Repair Type: Non-Urgent Crossing Status: Found UCIP Comments: 04/23/2014 Dense vegetation limits the inspector's visibility to identify signs of pipe failure (leaks) along the landward slope. Recommend removing vegetation along pipe alignment to conduct proper inspection of structure. (DWR UCIP - W. Wylie) FIELD_STRUCT_DESC: 24-inch corrugated metal gravity drainage pipe through the levee, 11.1 feet below the crown. Flap gate on the waterside (WS) end. Concrete headwall on the landside (LS) end. Concrete U-shaped headwall on the WS end. [Additional Reference(s): DWR Levee Log, 2002. USACE San Joaquin O&M Manual 601.1, 1967, (HLM 22.94)]. FS Date: 4/23/2014

Headwall, pipe, and flapgate visible on WS toe.

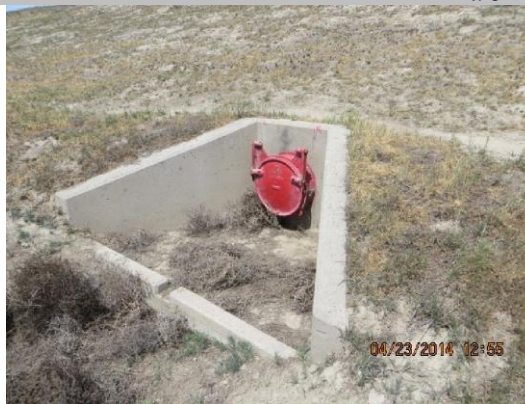
Photo 2 of 3 : UCIP\_SP\_2019\_39617\_62608.jpg

Headwall, pipe, and flapgate visible on WS toe.

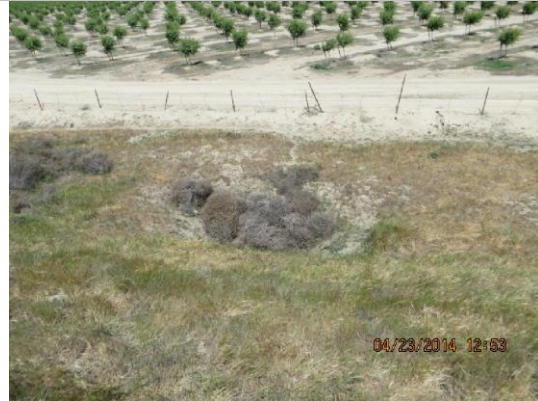
Photo 3 of 3 : UCIP\_SP\_2019\_39617\_62607.jpg

Item	DWR UCIP LMA Responsibility			37.075387 °	37.075387 °	
				-120.519406 °	-120.519406 °	
DWR ID	19792					
Comment Code						
Inspector Comment						
FS_ID:39617 DS_ID:19792 EP_NO: N/A Repair Type: Non-Urgent Crossing Status: Found UCIP Comments: 04/23/2014 Dense vegetation limits the inspector's visibility to identify signs of pipe failure (leaks) along the landward slope. Recommend removing vegetation along pipe alignment to conduct proper inspection of structure. (DWR UCIP - W. Wylie) FIELD_STRUCT_DESC: 24-inch corrugated metal gravity drainage pipe through the levee, 11.1 feet below the crown. Flap gate on the waterside (WS) end. Concrete headwall on the landside (LS) end. Concrete U-shaped headwall on the WS end. [Additional Reference(s): DWR Levee Log, 2002. USACE San Joaquin O&M Manual 601.1, 1967, (HLM 22.94)]. FS Date: 4/23/2014

Headwall and pipe visible on LS toe.

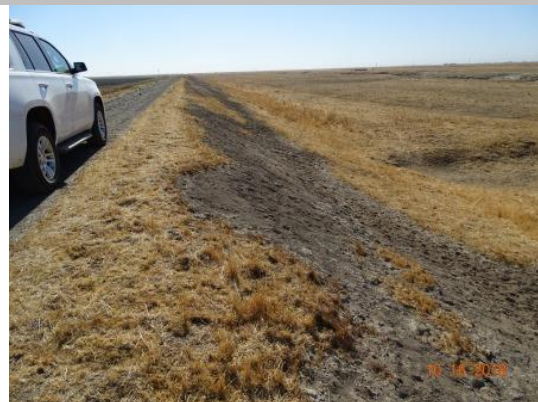
Photo 1 of 1 : SP\_2019\_NA0010\_123\_160\_20190307\_00051.jpg

LM Start	23.24	Rating **	A/W	Issue No.	160
LM End	23.25	Issue Type +	Ma	Location *	WS
Category	Earthen Levee			GPS Latitude/Longitude	
				Start	End
Item	Slope Stability			37.073064 °	37.072946 °
				-120.516771 °	-120.516634 °
DWR ID	DWR_NA0010_05_f_2018_160				
Comment Code					
S2 : Repair the levee slope damaged by foot traffic and prevent access where possible.					
Inspector Comment					
There is slope damage caused by livestock on waterside.

Slope damage cause by livestock foot traffic. (Fall 2018)

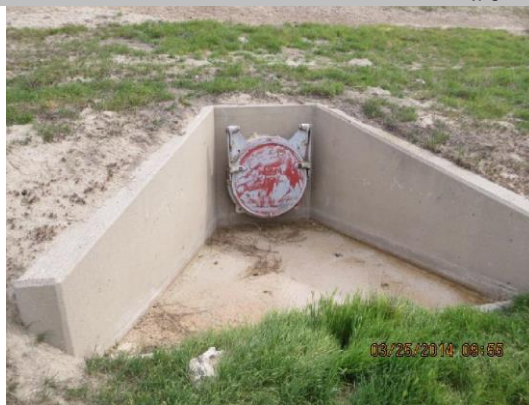
Photo 2 of 3 : UCIP\_SP\_2019\_32763\_59263.jpg

Flapgate and concrete headwall on WS toe.

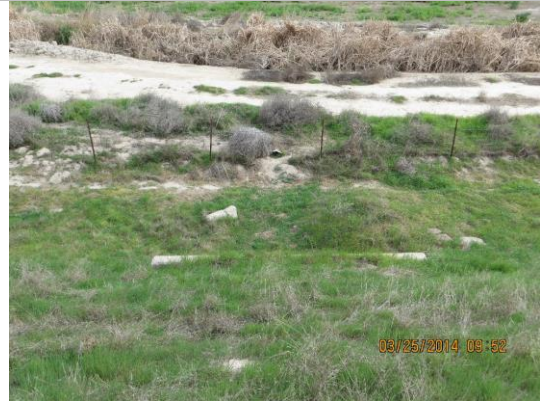
Photo 3 of 3 : UCIP\_SP\_2019\_32763\_59261.jpg

LM Start	23.25	Rating **	A/W	Issue No.	1371 (cont)
LM End	23.25	Issue Type +	Ma	Location *	
Category	Supplemental			GPS Latitude/Longitude	
				Start	End
Item	DWR UCIP LMA Responsibility			37.072989 °	37.072989 °
				-120.516687 °	-120.516687 °
DWR ID	19794				
Comment Code					
Inspector Comment					
FS_ID:32763					
DS_ID:19794					
EP_NO: N/A					
Repair Type: No Action Needed					
Crossing Status: Found					
UCIP Comments:					
FIELD_STRUCT_DESC: 30-inch corrugated metal gravity drainage pipe through the levee, 11.6 feet below the crown. Flap gate on the waterside (WS) end. Concrete headwall on the landside (LS) end. Concrete U-shaped headwall on the WS end. [Additional Reference(s): DWR Levee Log, 2002. USACE San Joaquin O&M Manual 601.1, 1967, (HLM 23.15)].					
FS Date: 3/25/2014 9:04:45 AM

Concrete headwall on LS toe.

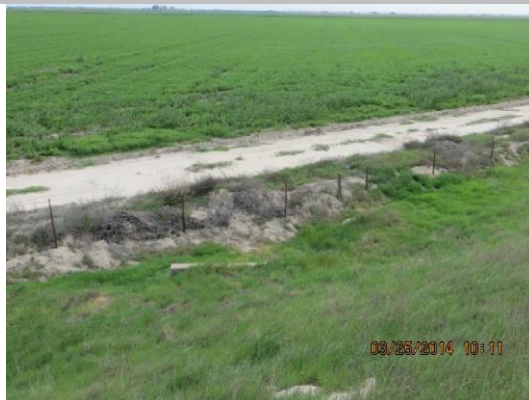
Photo 3 of 3 : UCIP\_SP\_2019\_39620\_59281.jpg

Concrete headwall on LS toe.

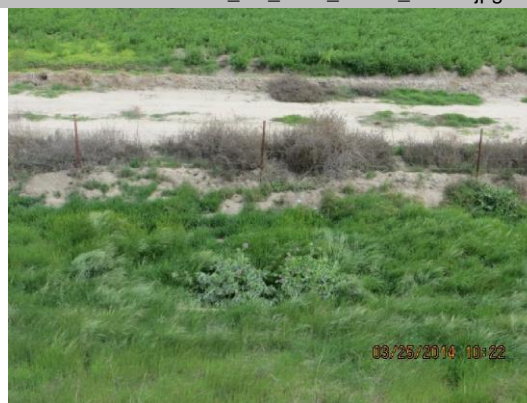
Photo 3 of 3 : UCIP\_SP\_2019\_46850\_59286.jpg

Item	DWR UCIP LMA Responsibility			37.061724 °	37.061724 °	
				-120.504512 °	-120.504512 °	
DWR ID	19798					
Comment Code						
Inspector Comment						
FS_ID:46850 DS_ID:19798 EP_NO: N/A Repair Type: Non-Urgent Crossing Status: Found UCIP Comments: 03/25/2014 Dense vegetation limits the inspector's visibility to identify signs of pipe failure (leaks) along the landward slope. Recommend removing vegetation along pipe alignment to conduct proper inspection of structure. (DWR UCIP - W. Wylie) FIELD_STRUCT_DESC: 24-inch corrugated metal gravity drainage pipe through the levee, 11.2 feet below the crown. Flap gate on the waterside (WS) end. Concrete headwall on the landside (LS) end. Concrete U-shaped headwall on the WS end. [Additional Reference(s): DWR Levee Log, 2002. USACE San Joaquin O&M Manual 601.1, 1967, (HLM 24.18)]. FS Date: 3/25/2014

Concrete headwall at LS toe.

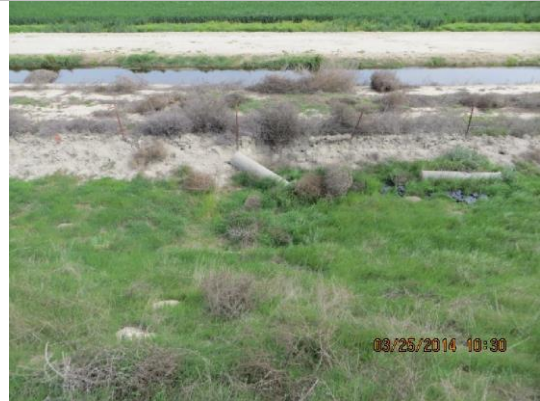
Photo 3 of 3 : UCIP\_SP\_2019\_39623\_59291.jpg

Item	DWR UCIP LMA Responsibility			37.058673 °	37.058673 °	
				-120.501238 °	-120.501238 °	
DWR ID	19799					
Comment Code						
Inspector Comment						
FS_ID:39623 DS_ID:19799 EP_NO: N/A Repair Type: Non-Urgent Crossing Status: Found UCIP Comments: 03/25/2014 Dense vegetation limits the inspector's visibility to identify signs of pipe failure (leaks) along the landward slope. Recommend removing vegetation along pipe alignment to conduct proper inspection of structure. (DWR UCIP - W. Wylie) FIELD_STRUCT_DESC: 24-inch corrugated metal gravity drainage pipe through the levee, 11.2 feet below the crown. Flap gate on the waterside (WS) end. Concrete headwall on the landside (LS) end. Concrete U-shaped headwall on the WS end. [Additional Reference(s): DWR Levee Log, 2002. USACE San Joaquin O&M Manual 601.1, 1967, (HLM 24.46)]. FS Date: 3/25/2014

Concrete headwall on LS toe.

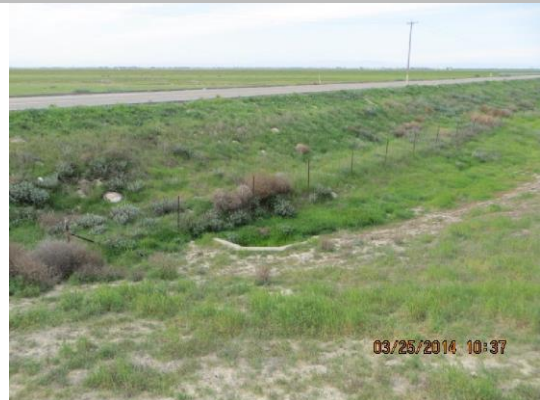
Photo 1 of 3 : UCIP\_SP\_2019\_32786\_59297.jpg

LM Start	24.93	Rating **	A/W	Issue No.	1376
LM End	24.93	Issue Type +	Ma	Location *	
Category	Supplemental			GPS Latitude/Longitude	
				Start	End
Item	DWR UCIP LMA Responsibility			37.054481 °	37.054481 °
				-120.496798 °	-120.496798 °
DWR ID	19800				
Comment Code					
Inspector Comment					
FS_ID:32786					
DS_ID:19800					
EP_NO: N/A					
Repair Type: No Action Needed					
Crossing Status: Found					
UCIP Comments:					
FIELD_STRUCT_DESC: 24-inch corrugated metal gravity drainage pipe through the levee, 10.7 feet below the crown. Flap gate on the waterside (WS) end. Concrete headwall on the landside (LS) end. Concrete U-shaped headwall on the WS end. [Additional Reference(s): DWR Levee Log, 2002. USACE San Joaquin O&M Manual 601.1, 1967, (HLM 24.82)].					
FS Date: 3/25/2014

Concrete headwall on WS toe.

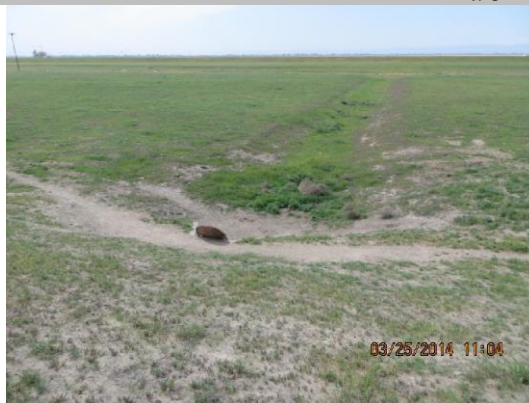
Photo 1 of 3 : UCIP\_SP\_2019\_32789\_59311.jpg

LM Start	25.24	Rating **	M	Issue No.	1379
LM End	25.24	Issue Type +	Ma	Location *	
Category	Supplemental			GPS Latitude/Longitude	
				Start	End
Item	DWR UCIP LMA Responsibility			37.051477 °	37.051477 °
				-120.492650 °	-120.492650 °
DWR ID	19803				
Comment Code					
Inspector Comment					
FS_ID:32789 DS_ID:19803 EP_NO: N/A Repair Type: Non-Urgent Crossing Status: Found UCIP Comments: 03/25/2014 Flapgate propped open during flood season. (DWR UCIP - W. Wylie) FIELD_STRUCT_DESC: 30-inch corrugated metal gravity drainage pipe through the levee, 11.3 feet below the crown. Flap gate on the waterside (WS) end. Concrete headwall on the landside (LS) end. Concrete U-shaped headwall on the WS end. [Additional Reference(s): DWR Levee Log, 2002. USACE San Joaquin O&M Manual 601.1, 1967, (HLM 25.43)]. FS Date: 3/25/2014

Concrete headwall and flapgate on WS toe.

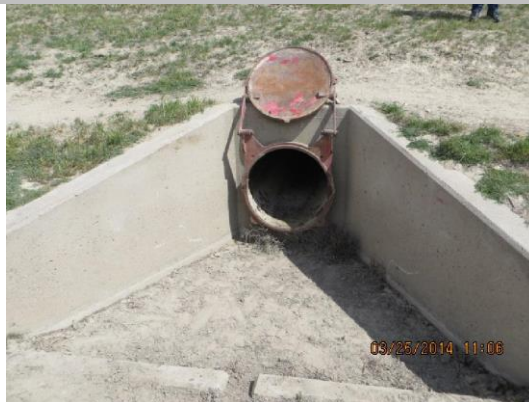
Photo 2 of 3 : UCIP\_SP\_2019\_32789\_59312.jpg

Concrete headwall and flapgate on WS toe.

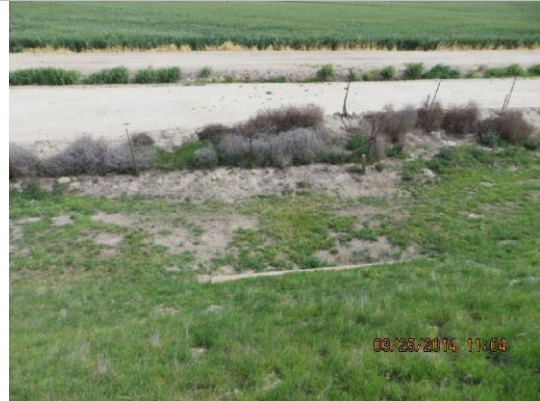
Photo 3 of 3 : UCIP\_SP\_2019\_32789\_59310.jpg

LM Start	25.24	Rating **	M	Issue No.	1379 (cont)
LM End	25.24	Issue Type +	Ma	Location *	
Category	Supplemental			GPS Latitude/Longitude	
				Start	End
Item	DWR UCIP LMA Responsibility			37.051477 °	37.051477 °
				-120.492650 °	-120.492650 °
DWR ID	19803				
Comment Code					
Inspector Comment					
FS_ID:32789 DS_ID:19803 EP_NO: N/A Repair Type: Non-Urgent Crossing Status: Found UCIP Comments: 03/25/2014 Flapgate propped open during flood season. (DWR UCIP - W. Wylie) FIELD_STRUCT_DESC: 30-inch corrugated metal gravity drainage pipe through the levee, 11.3 feet below the crown. Flap gate on the waterside (WS) end. Concrete headwall on the landside (LS) end. Concrete U-shaped headwall on the WS end. [Additional Reference(s): DWR Levee Log, 2002. USACE San Joaquin O&M Manual 601.1, 1967, (HLM 25.43)]. FS Date: 3/25/2014

Concrete headwall on LS toe.

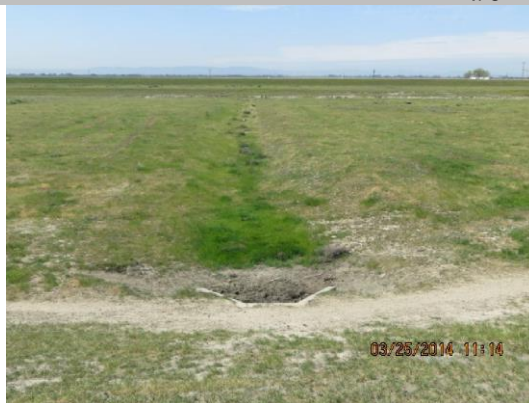
Photo 1 of 3 : UCIP\_SP\_2019\_39625\_59316.jpg

Comment Code					
Inspector Comment					
FS_ID:39625 DS_ID:19804 EP_NO: N/A Repair Type: Non-Urgent Crossing Status: Found UCIP Comments: 03/25/2014 Dense vegetation limits the inspector's visibility to identify signs of pipe failure (leaks) along the landward slope. Recommend removing vegetation along pipe alignment to conduct proper inspection of structure. Sediment buildup in pipe visible from landward side--recommend contacting owner to clear pipe. (DWR UCIP - W. Wylie) FIELD_STRUCT_DESC: 30-inch corrugated metal gravity drainage pipe through the levee, 12 feet below the crown. Flap gate on the waterside (WS) end. Concrete headwall on the landside (LS) end. Concrete U-shaped headwall on the WS end. [Additional Reference(s): DWR Levee Log, 2002. USACE San Joaquin O&M Manual 601.1, 1967, (HLM 25.51)]. FS Date: 3/25/2014

Concrete headwall on WS toe.

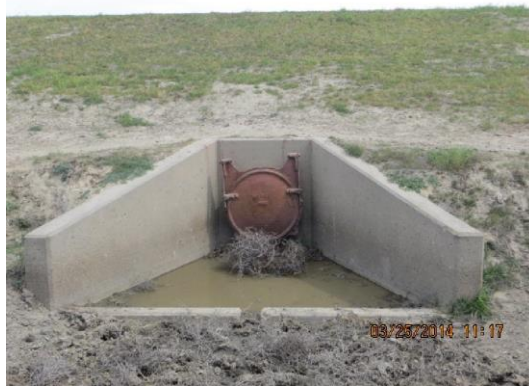
Photo 2 of 3 : UCIP\_SP\_2019\_39625\_59317.jpg

Flapgate on concrete headwall at WS toe.

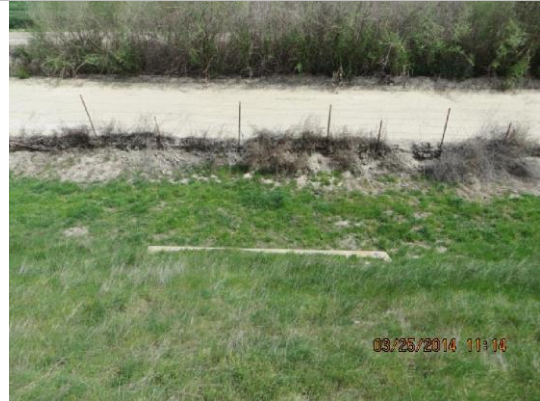
Photo 3 of 3 : UCIP\_SP\_2019\_39625\_59315.jpg

Comment Code					
Inspector Comment					
FS_ID:39625 DS_ID:19804 EP_NO: N/A Repair Type: Non-Urgent Crossing Status: Found UCIP Comments: 03/25/2014 Dense vegetation limits the inspector's visibility to identify signs of pipe failure (leaks) along the landward slope. Recommend removing vegetation along pipe alignment to conduct proper inspection of structure. Sediment buildup in pipe visible from landward side--recommend contacting owner to clear pipe. (DWR UCIP - W. Wylie) FIELD_STRUCT_DESC: 30-inch corrugated metal gravity drainage pipe through the levee, 12 feet below the crown. Flap gate on the waterside (WS) end. Concrete headwall on the landside (LS) end. Concrete U-shaped headwall on the WS end. [Additional Reference(s): DWR Levee Log, 2002. USACE San Joaquin O&M Manual 601.1, 1967, (HLM 25.51)]. FS Date: 3/25/2014

Concrete headwall on LS toe.

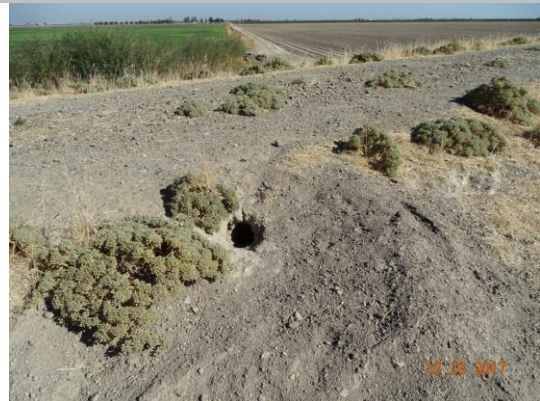
Photo 1 of 1 : SP\_2019\_NA0010\_123\_124\_20190307\_00025.jpg

LM Start	25.61	Rating **	M	Issue No.	124
LM End	25.61	Issue Type +	Ma	Location *	WS
Category	Earthen Levee			GPS Latitude/Longitude	
				Start	End
Item	Animal Control			37.047416 °	37.047416 °
				-120.488411 °	-120.488411 °
DWR ID	DWR_NA0010_05_f_2017_124				
Comment Code					
A3 : No rodents visible, but rodent burrows visible; need to backfill and compact or grout burrows.					
Inspector Comment

Looking east at the waterside slope.

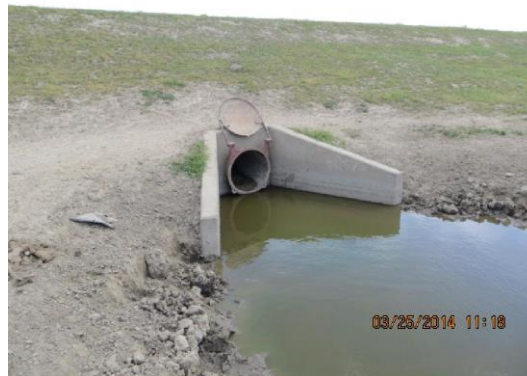
Photo 1 of 3 : UCIP\_SP\_2019\_39626\_59321.jpg

LM Start	25.63	Rating **	M	Issue No.	1381	
LM End	25.63	Issue Type +	Ma	Location *		
Category	Supplemental			GPS Latitude/Longitude		
				Start		End
Item	DWR UCIP LMA Responsibility			37.047170 °		37.047170 °
				-120.488222 °		-120.488222 °
DWR ID	19805					
Comment Code						
Inspector Comment						
FS_ID:39626 DS_ID:19805 EP_NO: N/A Repair Type: Non-Urgent Crossing Status: Found UCIP Comments: 03/25/2014 Sediment buildup in pipe visible from landward side--recommend contacting owner to clear pipe. (DWR UCIP - W. Wylie) FIELD_STRUCT_DESC: 30-inch corrugated metal gravity drainage pipe through the levee, 12.1 feet below the crown. Flap gate on the waterside (WS) end. Concrete headwall on the landside (LS) end. Concrete U-shaped headwall on the WS end. [Additional Reference(s): DWR Levee Log, 2002. USACE San Joaquin O&M Manual 601.1, 1967, (HLM 25.53)]. FS Date: 3/25/2014

Flapgate on headwall at WS toe.

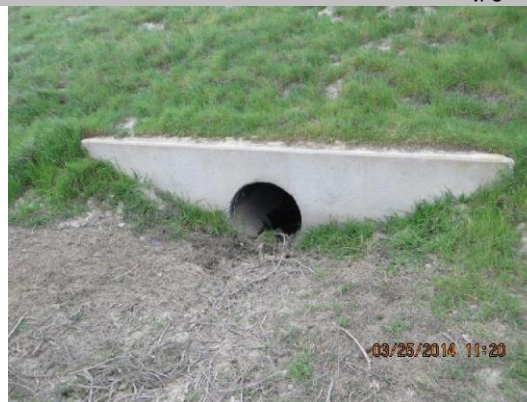
Photo 2 of 3 : UCIP\_SP\_2019\_39626\_59320.jpg

Concrete headwall on LS toe.

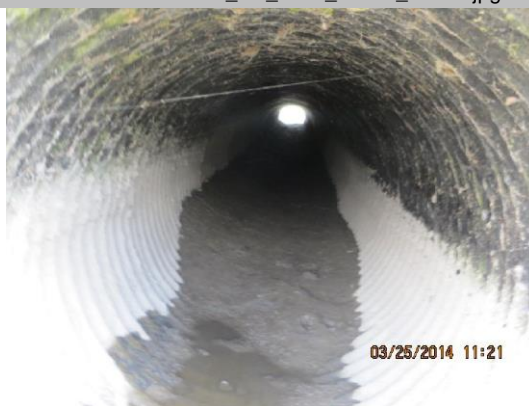
Photo 3 of 3 : UCIP\_SP\_2019\_39626\_59319.jpg

LM Start	25.63	Rating **	M	Issue No.	1381 (cont)	
LM End	25.63	Issue Type +	Ma	Location *		
Category	Supplemental			GPS Latitude/Longitude		
				Start		End
Item	DWR UCIP LMA Responsibility			37.047170 °	37.047170 °	
				-120.488222 °	-120.488222 °	
DWR ID	19805					
Comment Code						
Inspector Comment						
FS_ID:39626 DS_ID:19805 EP_NO: N/A Repair Type: Non-Urgent Crossing Status: Found UCIP Comments: 03/25/2014 Sediment buildup in pipe visible from landward side--recommend contacting owner to clear pipe. (DWR UCIP - W. Wylie) FIELD_STRUCT_DESC: 30-inch corrugated metal gravity drainage pipe through the levee, 12.1 feet below the crown. Flap gate on the waterside (WS) end. Concrete headwall on the landside (LS) end. Concrete U-shaped headwall on the WS end. [Additional Reference(s): DWR Levee Log, 2002. USACE San Joaquin O&M Manual 601.1, 1967, (HLM 25.53)]. FS Date: 3/25/2014

Inside pipe on LS toe.

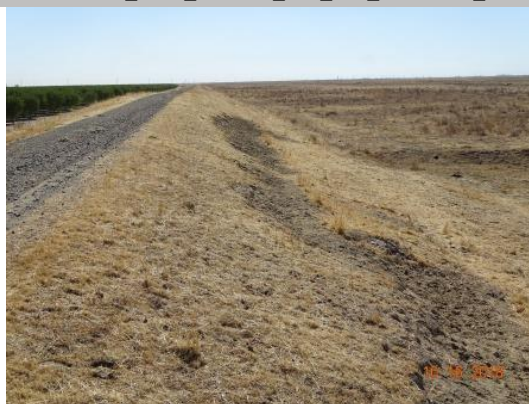
Photo 1 of 1 : SP\_2019\_NA0010\_123\_161\_20190307\_00052.jpg

LM Start	26.19	Rating **	M	Issue No.	161
LM End	26.21	Issue Type +	Ma	Location *	WS
Category	Earthen Levee			GPS Latitude/Longitude	
				Start	End
Item	Slope Stability			37.040289 °	37.040043 °
				-120.482988 °	-120.482795 °
DWR ID	DWR_NA0010_05_f_2018_161				
Comment Code					
S2 : Repair the levee slope damaged by foot traffic and prevent access where possible.					
Inspector Comment					
Waterside slope damage is caused by livestock foot traffic.

Slope damage on waterside. (Fall 2018)

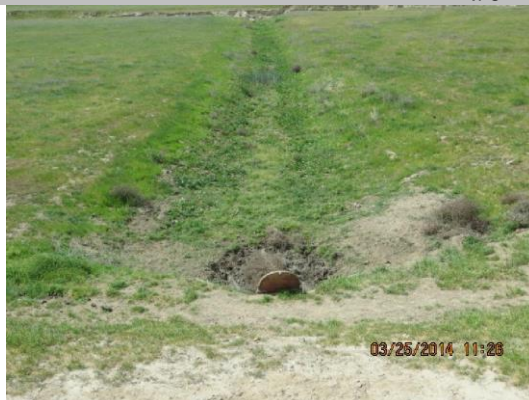
Photo 1 of 3 : UCIP\_SP\_2019\_39627\_59341.jpg

LM Start	26.20	Rating **	M	Issue No.	1382
LM End	26.20	Issue Type +	Ma	Location *	
Category	Supplemental			GPS Latitude/Longitude	
				Start	End
Item	DWR UCIP LMA Responsibility			37.040070 °	37.040070 °
				-120.482796 °	-120.482796 °
DWR ID	19806				
Comment Code					
Inspector Comment					
FS_ID:39627 DS_ID:19806 EP_NO: N/A Repair Type: Non-Urgent Crossing Status: Found UCIP Comments: 03/25/2014 Sediment buildup in pipe visible from landward side--recommend contacting owner to clear pipe. (DWR UCIP - W. Wylie) FIELD_STRUCT_DESC: 24-inch corrugated metal gravity drainage pipe through the levee, 10 feet below the crown. Flap gate on the waterside (WS) end. Concrete headwall on the landside (LS) end. Concrete U-shaped headwall on the WS end. [Additional Reference(s): DWR Levee Log, 2002. USACE San Joaquin O&M Manual 601.1, 1967, (HLM 26.11)]. FS Date: 3/25/2014

Concrete headwall on WS toe.

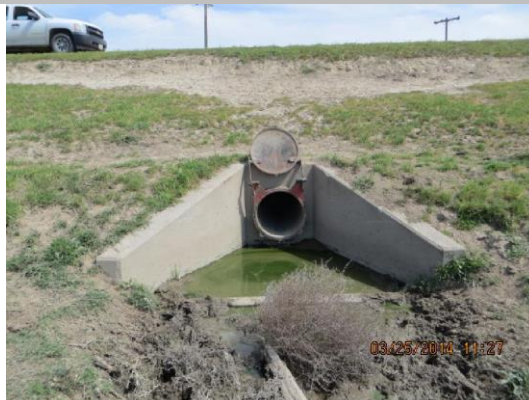
Photo 2 of 3 : UCIP\_SP\_2019\_39627\_59340.jpg

Flapgate on Concrete headwall at WS toe.

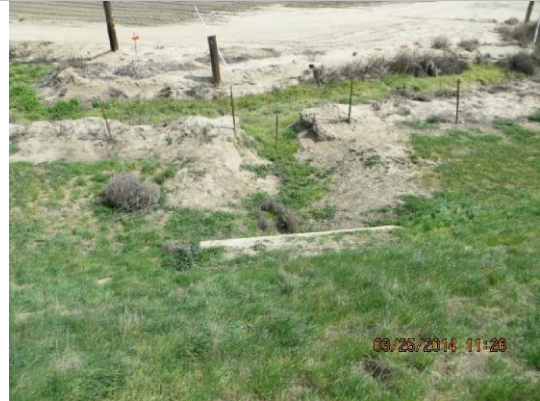
Photo 3 of 3 : UCIP\_SP\_2019\_39627\_59342.jpg

Item	DWR UCIP LMA Responsibility			37.040070 °		37.040070 °
				-120.482796 °		-120.482796 °
DWR ID	19806					
Comment Code						
Inspector Comment						
FS_ID:39627						
DS_ID:19806						
EP_NO: N/A						
Repair Type: Non-Urgent						
Crossing Status: Found						
UCIP Comments: 03/25/2014 Sediment buildup in pipe visible from landward side--recommend contacting owner to clear pipe. (DWR UCIP - W. Wylie)						
FIELD_STRUCT_DESC: 24-inch corrugated metal gravity drainage pipe through the levee, 10 feet below the crown. Flap gate on the waterside (WS) end. Concrete headwall on the landside (LS) end. Concrete U-shaped headwall on the WS end. [Additional Reference(s): DWR Levee Log, 2002. USACE San Joaquin O&M Manual 601.1, 1967, (HLM 26.11)].						
FS Date: 3/25/2014

Concrete headwall on LS toe.

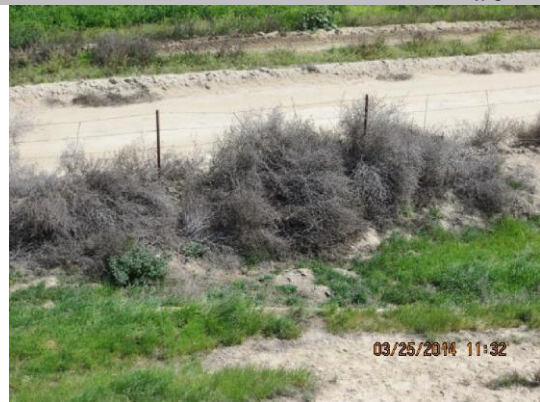
Photo 1 of 3 : UCIP\_SP\_2019\_32804\_59347.jpg

LM Start	26.39	Rating **	A/W	Issue No.	1383
LM End	26.39	Issue Type +	Ma	Location *	
Category	Supplemental			GPS Latitude/Longitude	
				Start	End
Item	DWR UCIP LMA Responsibility			37.037772 °	37.037772 °
				-120.481028 °	-120.481028 °
DWR ID	19807				
Comment Code					
Inspector Comment					
FS_ID:32804 DS_ID:19807 EP_NO: N/A Repair Type: No Action Needed Crossing Status: Found UCIP Comments: FIELD_STRUCT_DESC: 36-inch corrugated metal gravity drainage pipe through the levee, 13 feet below the crown. Flap gate on the waterside (WS) end. Concrete headwall on the landside (LS) end. Concrete U-shaped headwall on the WS end. [Additional Reference(s): DWR Levee Log, 2002. USACE San Joaquin O&M Manual 601.1, 1967, (HLM 26.29)]. FS Date: 3/25/2014

Concrete headwall on LS toe.

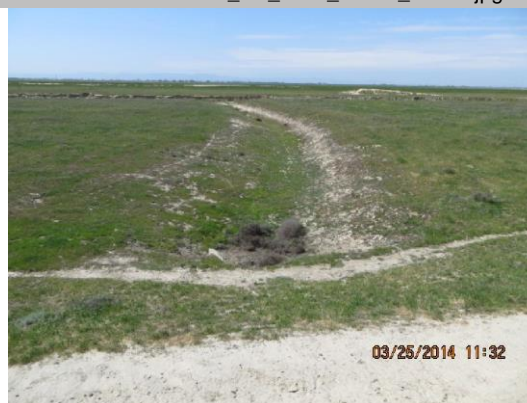
Photo 2 of 3 : UCIP\_SP\_2019\_32804\_59346.jpg

Concrete headwall on WS toe.

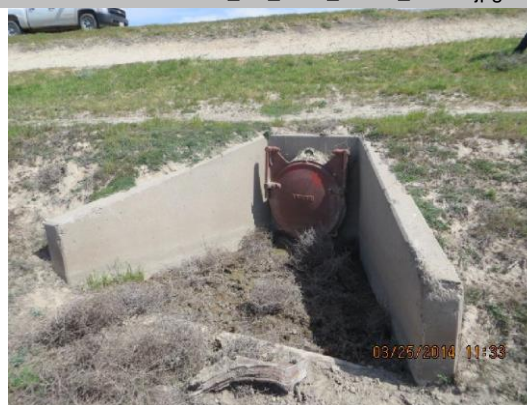
Photo 3 of 3 : UCIP\_SP\_2019\_32804\_59345.jpg

Flapgate on Concrete headwall at WS toe.

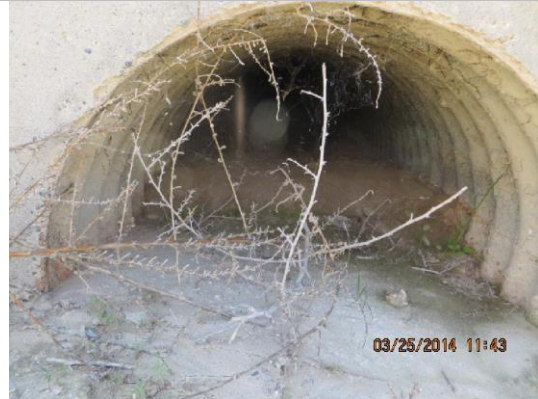
Photo 3 of 3 : UCIP\_SP\_2019\_39628\_59348.jpg

LM Start	26.95	Rating **	M	Issue No.	1384 (cont)	
LM End	26.95	Issue Type +	Ma	Location *		
Category	Supplemental			GPS Latitude/Longitude		
				Start	End	
Item	DWR UCIP LMA Responsibility			37.032669 °	37.032669 °	
				-120.473901 °	-120.473901 °	
DWR ID	19808					
Comment Code						
Inspector Comment						
FS_ID:39628 DS_ID:19808 EP_NO: N/A Repair Type: Non-Urgent Crossing Status: Found UCIP Comments: 03/25/2014 Pipe has heavy silt buildup visible from landward side--recommend contacting owner to clear pipe. (DWR UCIP - W. Wylie) FIELD_STRUCT_DESC: 24-inch corrugated metal gravity drainage pipe through the levee, 11.4 feet below the crown. Flap gate on the waterside (WS) end. Concrete headwall on the landside (LS) end. Concrete U-shaped headwall on the WS end. [Additional Reference(s): DWR Levee Log, 2002. USACE San Joaquin O&M Manual 601.1, 1967, (HLM 26.85)]. FS Date: 3/25/2014

Silt buildup in pipe at LS toe.

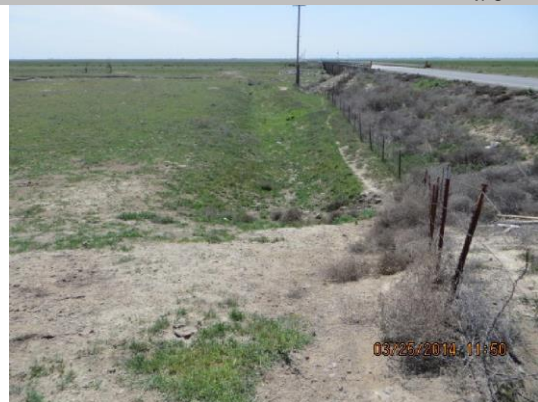
Photo 1 of 3 : UCIP\_SP\_2019\_32806\_59353.jpg

LM Start	26.97	Rating **	M	Issue No.	1385
LM End	26.97	Issue Type +	Ma	Location *	
Category	Supplemental			GPS Latitude/Longitude	
				Start	End
Item	DWR UCIP LMA Responsibility			37.032680 °	37.032680 °
				-120.473454 °	-120.473454 °
DWR ID	19748				
Comment Code					
Inspector Comment					
FS_ID:32806 DS_ID:19748 EP_NO: N/A Repair Type: Non-Urgent Crossing Status: Found UCIP Comments: 03/25/2014 Tumble weed buildup at inlet mat create blockage and should be removed. (DWR UCIP - W. Wylie) FIELD_STRUCT_DESC: 24-inch corrugated metal gravity drainage pipe through the levee, 11.3 feet below the crown. Flap gate on the waterside (WS) end. Concrete headwall on the landside (LS) end. Concrete U-shaped headwall on the WS end. [Additional Reference(s): DWR Levee Log, 2002. USACE San Joaquin O&M Manual 601.1, 1967, (HLM 26.87)]. FS Date: 3/25/2014

Concrete headwall at WS toe.

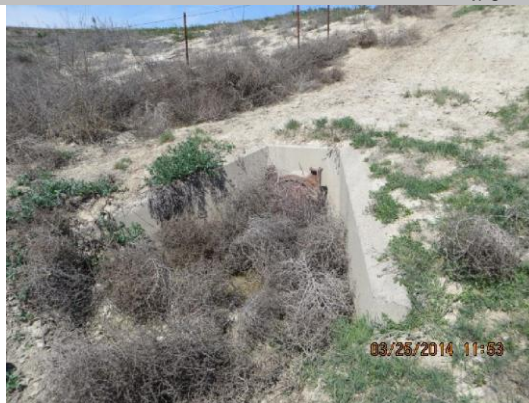
Photo 2 of 3 : UCIP\_SP\_2019\_32806\_59355.jpg

Flapgate and Concrete headwall at WS toe.

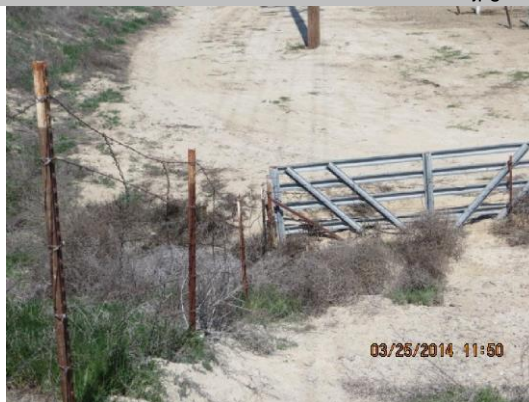
Photo 3 of 3 : UCIP\_SP\_2019\_32806\_59354.jpg

Concrete headwall at LS toe.

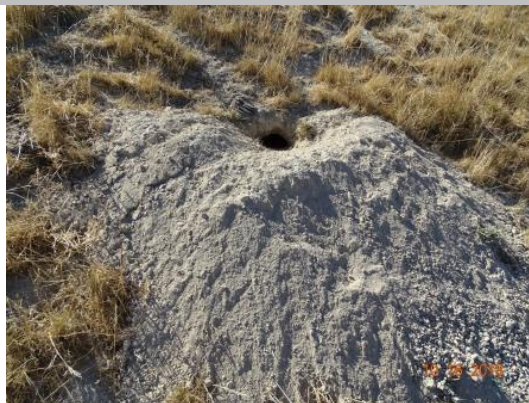
Photo 1 of 1 : SP\_2019\_NA0010\_123\_162\_20190307\_00053.jpg

LM Start	27.00	Rating **	U	Issue No.	162
LM End	27.04	Issue Type +	Ma	Location *	LS
Category	Earthen Levee			GPS Latitude/Longitude	
				Start	End
Item	Animal Control			37.032663 °	37.032659 °
				-120.472907 °	-120.472190 °
DWR ID	DWR_NA0010_05_f_2018_162				
Comment Code					
A3 : No rodents visible, but rodent burrows visible; need to backfill and compact or grout burrows.					
Inspector Comment					
Several rodent burrows with large quantities of material displaced noted in this section.

Rodent burrow noted with large quantity of material displaced. (Fall 2018)

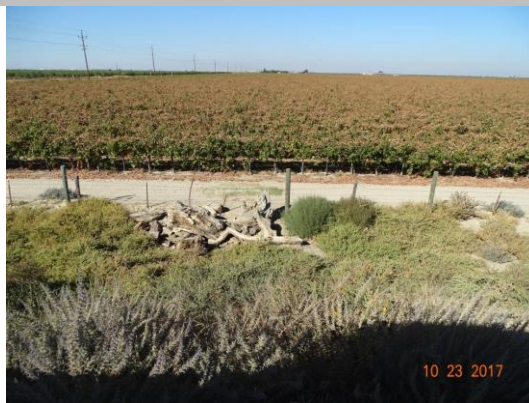
Photo 1 of 1 : SP\_2019\_NA0010\_123\_125\_20190307\_00026.jpg

LM Start	27.01	Rating **	M	Issue No.	125	
LM End	27.01	Issue Type +	Ma	Location *	LS	
Category	Earthen Levee			GPS Latitude/Longitude		
				Start		End
Item	Encroachments			37.032675 °		37.032675 °
				-120.472841 °		-120.472841 °
DWR ID	DWR_NA0010_05_f_2017_125					
Comment Code						
TR : Tree or limb						
Inspector Comment

Looking north at the landside slope.

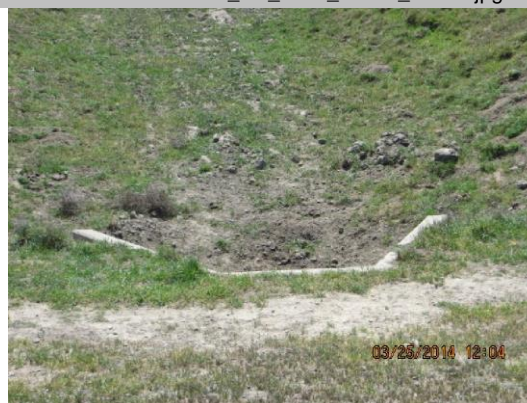
Photo 1 of 3 : UCIP\_SP\_2019\_32807\_59358.jpg

LM Start	27.31	Rating **	A/W	Issue No.	1386
LM End	27.31	Issue Type +	Ma	Location *	
Category	Supplemental			GPS Latitude/Longitude	
				Start	End
Item	DWR UCIP LMA Responsibility			37.032668 °	37.032668 °
				-120.467299 °	-120.467299 °
DWR ID	19749				
Comment Code					
Inspector Comment					
FS_ID:32807					
DS_ID:19749					
EP_NO: N/A					
Repair Type: No Action Needed					
Crossing Status: Found					
UCIP Comments:					
FIELD_STRUCT_DESC: 36-inch corrugated metal gravity drainage pipe through the levee, 12 feet below the crown. Flap gate on the waterside (WS) end. Concrete headwall on the landside (LS) end. Concrete U-shaped headwall on the WS end. [Additional Reference(s): DWR Levee Log, 2002. USACE San Joaquin O&M Manual 601.1, 1967, (HLM 27.22)].					
FS Date: 3/25/2014

Concrete headwall on WS toe.

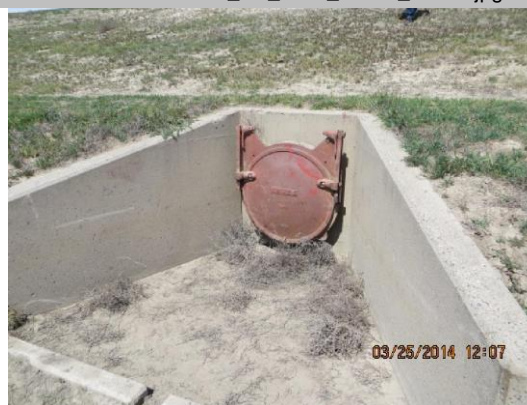
Photo 2 of 3 : UCIP\_SP\_2019\_32807\_59359.jpg

Flapgate at Concrete headwall on WS toe.

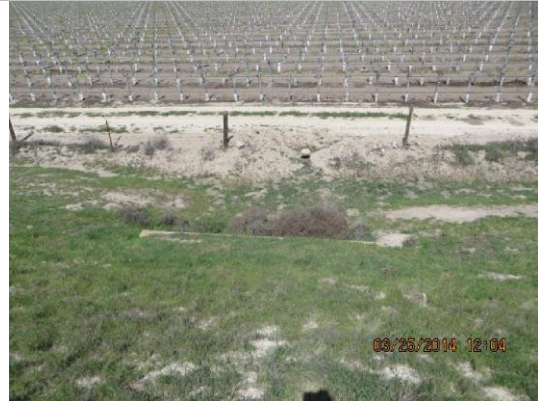
Photo 3 of 3 : UCIP\_SP\_2019\_32807\_59357.jpg

LM Start	27.31	Rating **	A/W	Issue No.	1386 (cont)	
LM End	27.31	Issue Type +	Ma	Location *		
Category	Supplemental			GPS Latitude/Longitude		
				Start	End	
Item	DWR UCIP LMA Responsibility			37.032668 °	37.032668 °	
				-120.467299 °	-120.467299 °	
DWR ID	19749					
Comment Code						
Inspector Comment						
FS_ID:32807						
DS_ID:19749						
EP_NO: N/A						
Repair Type: No Action Needed						
Crossing Status: Found						
UCIP Comments:						
FIELD_STRUCT_DESC: 36-inch corrugated metal gravity drainage pipe through the levee, 12 feet below the crown. Flap gate on the waterside (WS) end. Concrete headwall on the landside (LS) end. Concrete U-shaped headwall on the WS end. [Additional Reference(s): DWR Levee Log, 2002. USACE San Joaquin O&M Manual 601.1, 1967, (HLM 27.22)].						
FS Date: 3/25/2014

Concrete headwall on LS toe.

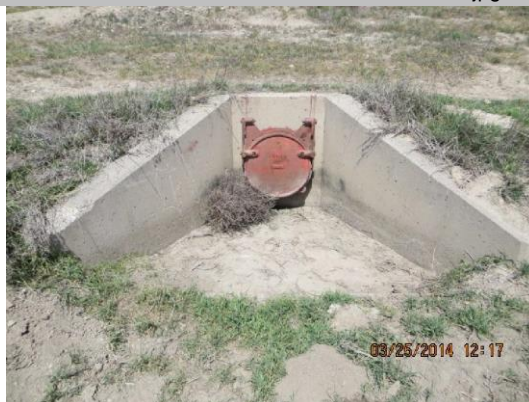
Photo 2 of 3 : UCIP\_SP\_2019\_32823\_59383.jpg

Flapgate on Concrete headwall at WS toe.

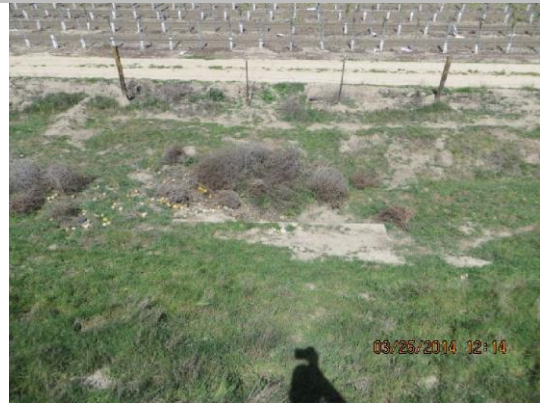
Photo 3 of 3 : UCIP\_SP\_2019\_32823\_59381.jpg

LM Start	28.27	Rating **	M	Issue No.	1387 (cont)	
LM End	28.27	Issue Type +	Ma	Location *		
Category	Supplemental			GPS Latitude/Longitude		
				Start	End	
Item	DWR UCIP LMA Responsibility			37.032623 °	37.032623 °	
				-120.450108 °	-120.450108 °	
DWR ID	19750					
Comment Code						
Inspector Comment						
FS_ID:32823 DS_ID:19750 EP_NO: N/A Repair Type: Non-Urgent Crossing Status: Found UCIP Comments: 03/25/2014 Animal Burrowing activity at LS toe may undermine headwall. (DWR UCIP - W. Wylie) FIELD_STRUCT_DESC: 24-inch corrugated metal gravity drainage pipe through the levee, 10.8 feet below the crown. Flap gate on the waterside (WS) end. Concrete headwall on the landside (LS) end. Concrete U-shaped headwall on the WS end. [Additional Reference(s): DWR Levee Log, 2002. USACE San Joaquin O&M Manual 601.1, 1967, (HLM 28.17)]. FS Date: 3/25/2014

Concrete headwall on LS toe.

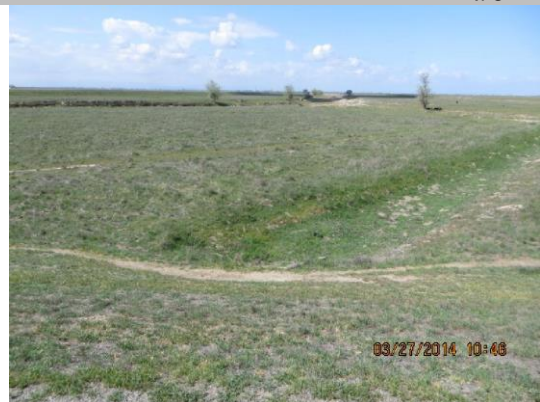
Photo 1 of 3 : UCIP\_SP\_2019\_32832\_59420.jpg

LM Start	28.79	Rating **	A/W	Issue No.	1388
LM End	28.79	Issue Type +	Ma	Location *	
Category	Supplemental			GPS Latitude/Longitude	
				Start	End
Item	DWR UCIP LMA Responsibility			37.031640 °	37.031640 °
				-120.441389 °	-120.441389 °
DWR ID	19751				
Comment Code					
Inspector Comment					
FS_ID:32832 DS_ID:19751 EP_NO: N/A Repair Type: No Action Needed Crossing Status: Found UCIP Comments: FIELD_STRUCT_DESC: 30-inch corrugated metal gravity drainage pipe through the levee, 9.8 feet below the crown. Flap gate on the waterside (WS) end. Concrete headwall on the landside (LS) end. Concrete U-shaped headwall on the WS end. [Additional Reference(s): DWR Levee Log, 2002. USACE San Joaquin O&M Manual 601.1, 1967, (HLM 28.69)]. FS Date: 3/27/2014

Concrete headwall on WS toe.

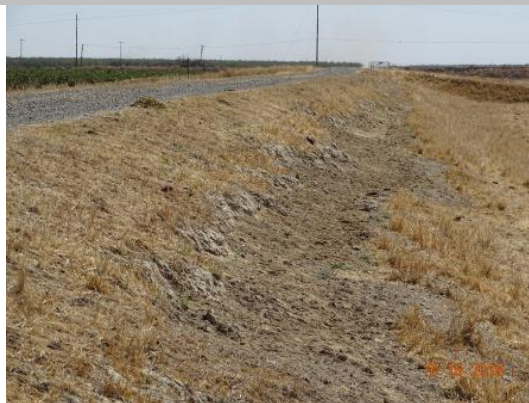
Photo 1 of 1 : SP\_2019\_NA0010\_123\_164\_20190307\_00054.jpg

LM Start	29.43	Rating **	M	Issue No.	164
LM End	29.59	Issue Type +	Ma	Location *	WS
Category	Earthen Levee			GPS Latitude/Longitude	
				Start	End
Item	Slope Stability			37.023481 °	37.021442 °
				-120.435960 °	-120.434564 °
DWR ID	DWR_NA0010_05_f_2018_164				
Comment Code					
S2 : Repair the levee slope damaged by foot traffic and prevent access where possible.					
Inspector Comment					
There is slope damage on waterside from livestock traffic.

Slope damage from animal traffic. (Fall 2018)

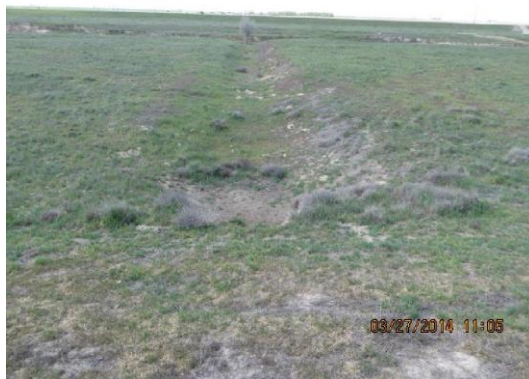
Photo 1 of 3 : UCIP\_SP\_2019\_39884\_59414.jpg

Comment Code					
Inspector Comment					
FS_ID:39884 DS_ID:19753 EP_NO: N/A Repair Type: Non-Urgent Crossing Status: Found UCIP Comments: 03/27/2014 Dense vegetation limits the inspector's visibility to identify signs of pipe failure (leaks) along the landward slope. Recommend removing vegetation along pipe alignment to conduct proper inspection of structure. Sediment buildup in pipe visible from landward side--recommend contacting owner to clear pipe. (DWR UCIP - W. Wylie) FIELD_STRUCT_DESC: 36-inch corrugated metal gravity drainage pipe through the levee, 10.2 feet below the crown. Flap gate on the waterside (WS) end. Concrete headwall on the landside (LS) end. Concrete U-shaped headwall on the WS end. [Additional Reference(s): DWR Levee Log, 2002. USACE San Joaquin O&M Manual 601.1, 1967, (HLM 29.49)]. FS Date: 3/27/2014

Concrete headwall on WS toe.

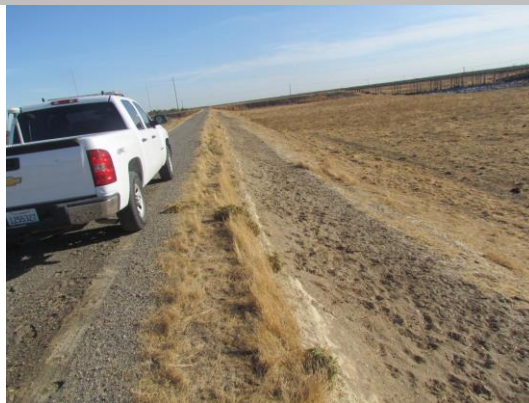
Photo 1 of 2 : SP\_2019\_NA0010\_123\_171\_20190307\_00059.jpg

LM Start	29.68	Rating **	M	Issue No.	171
LM End	29.80	Issue Type +	Ma	Location *	WS
Category	Earthen Levee			GPS Latitude/Longitude	
				Start	End
Item	Erosion / Bank Caving			37.020272 °	37.018712 °
				-120.433737 °	-120.432682 °
DWR ID	DWR_NA0010_05_s_2014_171				
Comment Code					
E1 : Note and monitor erosion site.					
Inspector Comment					
There is waterside erosion caused by livestock.

Looking south at animal erosion on waterward slope.

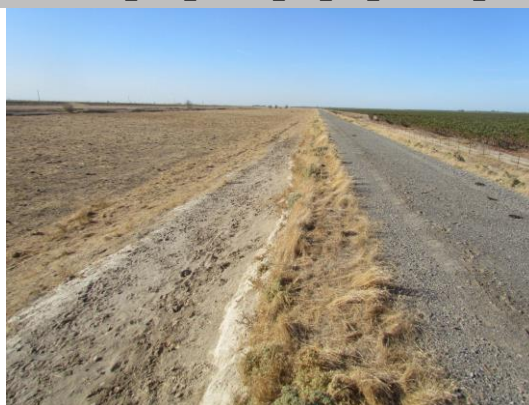
Photo 2 of 2 : SP\_2019\_NA0010\_123\_171\_20190307\_00060.jpg

Looking north at animal erosion on waterward slope.

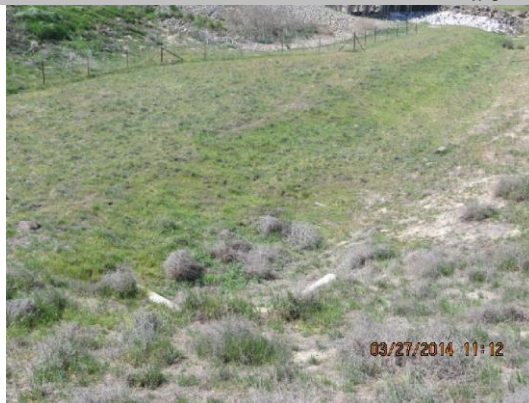
Photo 1 of 3 : UCIP\_SP\_2019\_39631\_59424.jpg

Comment Code					
Inspector Comment					
FS_ID:39631					
DS_ID:19754					
EP_NO: N/A					
Repair Type: Non-Urgent					
Crossing Status: Found					
UCIP Comments: 03/27/2014 Dense vegetation limits the inspector's visibility to identify signs of pipe failure (leaks) along the landward slope. Recommend removing vegetation along pipe alignment to conduct proper inspection of structure. (DWR UCIP - W. Wylie)					
FIELD_STRUCT_DESC: 30-inch by 30-inch reinforced concrete box gravity drainage culvert through the levee, 12 feet below the crown. Flap gate on the waterside (WS) end. Concrete headwall on the landside (LS) end. Concrete U-shaped headwall on the WS end. [Additional Reference(s): DWR Levee Log, 2002. USACE San Joaquin O&M Manual 601.1, 1967, (HLM 29.72)].					
FS Date: 3/27/2014

Concrete headwall on WS toe.
