**Flood Control Project Maintenance  
Levee Inspections**

## Maintenance Issue Types Only, Levee Inspection Report By Mile - Spring 2019

### Lower San Joaquin Levee District

Waterway	Bank	Unit Miles	Inspection Start/End	Inspector
Unit No. 01 San Joaquin River	Right	22.52	03/26/2019 03/26/2019	Corey Fujitani

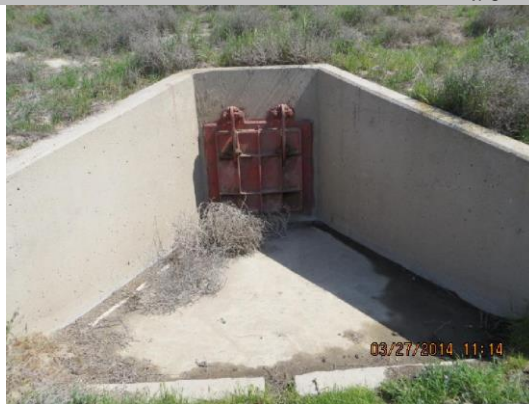
Photo 2 of 3 : UCIP\_SP\_2019\_39631\_59426.jpg

Flapgate on Concrete headwall at WS toe.

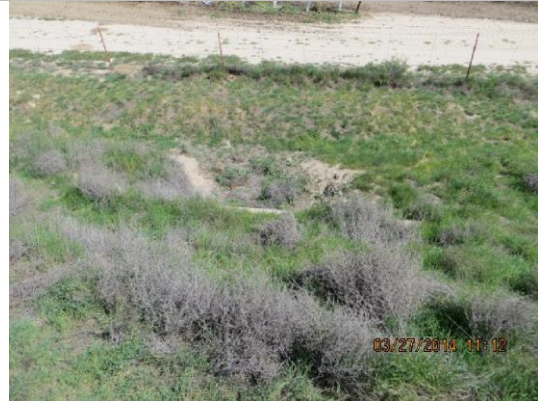
Photo 3 of 3 : UCIP\_SP\_2019\_39631\_59425.jpg

Item	DWR UCIP LMA Responsibility			37.018505 °		37.018505 °
				-120.432544 °		-120.432544 °
DWR ID	19754					
Comment Code						
Inspector Comment						
FS_ID:39631 DS_ID:19754 EP_NO: N/A Repair Type: Non-Urgent Crossing Status: Found UCIP Comments: 03/27/2014 Dense vegetation limits the inspector's visibility to identify signs of pipe failure (leaks) along the landward slope. Recommend removing vegetation along pipe alignment to conduct proper inspection of structure. (DWR UCIP - W. Wylie) FIELD_STRUCT_DESC: 30-inch by 30-inch reinforced concrete box gravity drainage culvert through the levee, 12 feet below the crown. Flap gate on the waterside (WS) end. Concrete headwall on the landside (LS) end. Concrete U-shaped headwall on the WS end. [Additional Reference(s): DWR Levee Log, 2002. USACE San Joaquin O&M Manual 601.1, 1967, (HLM 29.72)]. FS Date: 3/27/2014

Concrete headwall on LS toe.

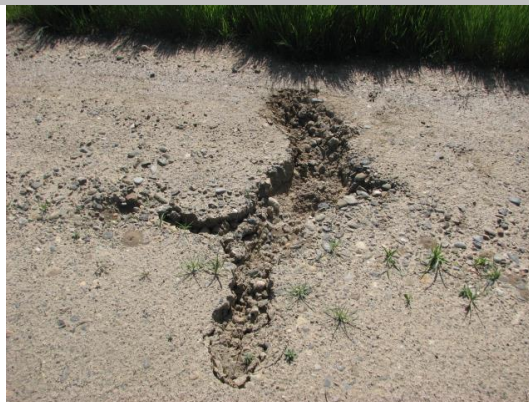
Photo 1 of 2 : SP\_2019\_NA0010\_123\_133\_20190307\_00032.jpg

LM Start	30.31	Rating **	M	Issue No.	133
LM End	30.31	Issue Type +	Ma	Location *	CR
Category	Earthen Levee			GPS Latitude/Longitude	
				Start	End
Item	Crown Surface / Depressions / Rutting			37.012273 °	37.012273 °
				-120.428244 °	-120.428244 °
DWR ID	DWR_NA0010_05_s_2018_133				
Comment Code					
C2 : Repair depressions or ruts in the crown or slope.					
Inspector Comment					
There is a minor depression on levee crown. Possible sink hole.

Looking east at depression on levee crown. (Spring 2018)

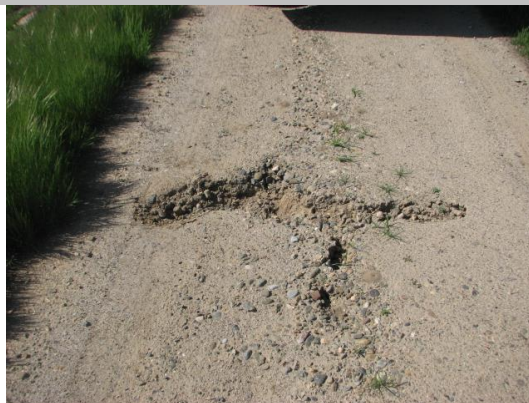
Photo 2 of 2 : SP\_2019\_NA0010\_123\_133\_20190307\_00033.jpg

LM Start	30.31	Rating **	M	Issue No.	133 (cont)	
LM End	30.31	Issue Type +	Ma	Location *	CR	
Category	Earthen Levee			GPS Latitude/Longitude		
				Start		End
Item	Crown Surface / Depressions / Rutting			37.012273 °		37.012273 °
				-120.428244 °		-120.428244 °
DWR ID	DWR_NA0010_05_s _ 2018_133					
Comment Code						
C2 : Repair depressions or ruts in the crown or slope.						
Inspector Comment						
There is a minor depression on levee crown. Possible sink hole.

Looking north at depression on levee crown. (Spring 2018)

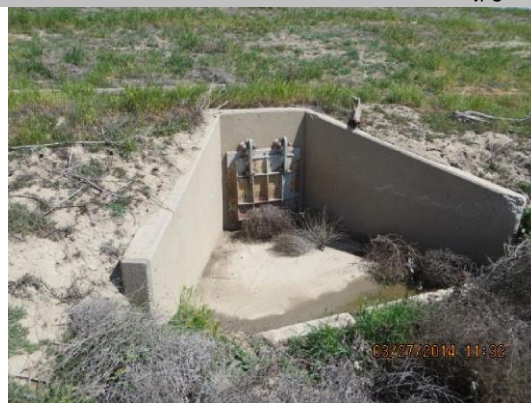
Photo 2 of 3 : UCIP\_SP\_2019\_39633\_59436.jpg

Flapgate on Concrete headwall at WS toe.

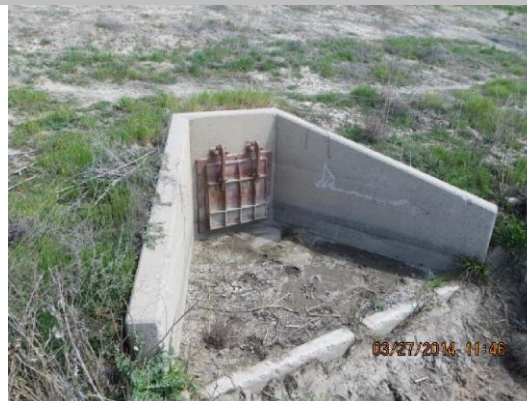
Photo 2 of 3 : UCIP\_SP\_2019\_39643\_59440.jpg

Flapgate at concrete headwall on WS toe.

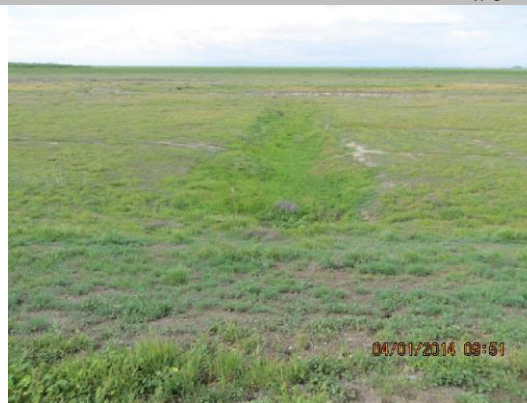
Photo 1 of 3 : UCIP\_SP\_2019\_39645\_59686.jpg

Comment Code					
Inspector Comment					
FS_ID:39645					
DS_ID:19700					
EP_NO: N/A					
Repair Type: Non-Urgent					
Crossing Status: Found					
UCIP Comments: 04/01/2014 Dense vegetation limits the inspector's visibility to identify signs of pipe failure (leaks) along the landward slope. Recommend removing vegetation along pipe alignment to conduct proper inspection of structure. (DWR UCIP - W. Wylie)					
FIELD_STRUCT_DESC: 30-inch by 30-inch reinforced concrete box gravity drainage culvert through the levee, 13 feet below the crown. Flap gate on the waterside (WS) end. Concrete headwall on the landside (LS) end with flashboard attachment. Concrete U-shaped headwall on the WS end. [Additional Reference(s): DWR Levee Log, 2002. USACE San Joaquin O&M Manual 601.1, 1967, (HLM 31.71)].					
FS Date: 4/1/2014

Concrete headwall at channel on WS toe.

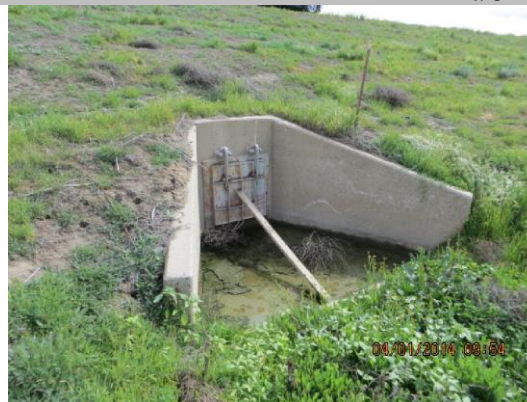
Photo 2 of 3 : UCIP\_SP\_2019\_39645\_59687.jpg

Flapgate on Concrete headwall at channel on WS toe.

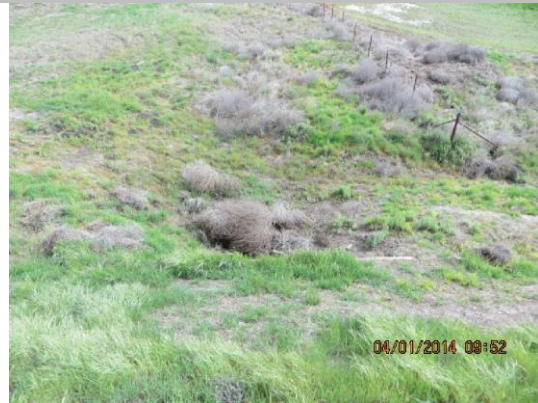
Photo 3 of 3 : UCIP\_SP\_2019\_39645\_59685.jpg

Item	DWR UCIP LMA Responsibility			36.995029 °		36.995029 °
				-120.408914 °		-120.408914 °
DWR ID	19700					
Comment Code						
Inspector Comment						
FS_ID:39645						
DS_ID:19700						
EP_NO: N/A						
Repair Type: Non-Urgent						
Crossing Status: Found						
UCIP Comments: 04/01/2014 Dense vegetation limits the inspector's visibility to identify signs of pipe failure (leaks) along the landward slope.						
Recommend removing vegetation along pipe alignment to conduct proper inspection of structure. (DWR UCIP - W. Wylie)						
FIELD_STRUCT_DESC: 30-inch by 30-inch reinforced concrete box gravity drainage culvert through the levee, 13 feet below the crown. Flap gate on the waterside (WS) end. Concrete headwall on the landside (LS) end with flashboard attachment. Concrete U-shaped headwall on the WS end. [Additional Reference(s): DWR Levee Log, 2002. USACE San Joaquin O&M Manual 601.1, 1967, (HLM 31.71)].

Concrete headwall on LS toe.

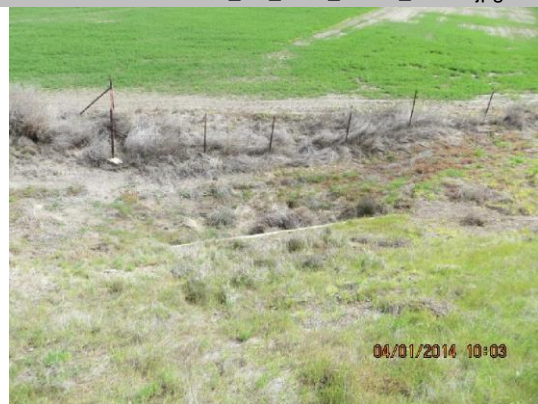
Photo 1 of 3 : UCIP\_SP\_2019\_39646\_59690.jpg

Comment Code					
Inspector Comment					
FS_ID:39646					
DS_ID:19701					
EP_NO: N/A					
Repair Type: Non-Urgent					
Crossing Status: Found					
UCIP Comments: 04/01/2014 Some silt buildup inside culvert. (DWR UCIP - W. Wylie)					
FIELD_STRUCT_DESC: 30-inch by 30-inch reinforced concrete box gravity drainage culvert through the levee, 14.2 feet below the crown. Flap gate on the waterside (WS) end. Concrete headwall on the landside (LS) end with flashboard attachment. Concrete U-shaped headwall on the WS end. [Additional Reference(s): DWR Levee Log, 2002. USACE San Joaquin O&M Manual 601.1, 1967, (HLM 32.22)].					
FS Date: 4/1/2014

Concrete headwall at inlet on LS toe.

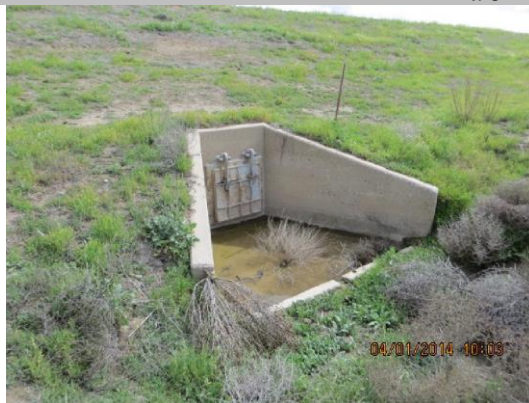
Photo 2 of 3 : UCIP\_SP\_2019\_39646\_59688.jpg

LM Start	32.32	Rating **	M	Issue No.	1397 (cont)	
LM End	32.32	Issue Type +	Ma	Location *		
Category	Supplemental			GPS Latitude/Longitude		
				Start		End
Item	DWR UCIP LMA Responsibility			36.989435 °		36.989435 °
				-120.402626 °		-120.402626 °
DWR ID	19701					
Comment Code						
Inspector Comment						
FS_ID:39646 DS_ID:19701 EP_NO: N/A Repair Type: Non-Urgent Crossing Status: Found UCIP Comments: 04/01/2014 Some silt buildup inside culvert. (DWR UCIP - W. Wylie) FIELD_STRUCT_DESC: 30-inch by 30-inch reinforced concrete box gravity drainage culvert through the levee, 14.2 feet below the crown. Flap gate on the waterside (WS) end. Concrete headwall on the landside (LS) end with flashboard attachment. Concrete U-shaped headwall on the WS end. [Additional Reference(s): DWR Levee Log, 2002. USACE San Joaquin O&M Manual 601.1, 1967, (HLM 32.22)]. FS Date: 4/1/2014

Flapgate on Concrete headwall at WS toe.

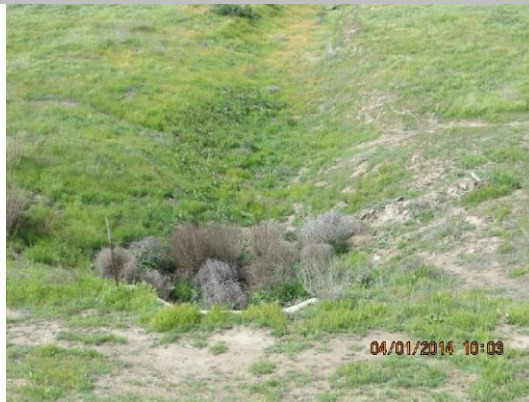
Photo 3 of 3 : UCIP\_SP\_2019\_39646\_59689.jpg

Concrete headwall at outlet on WS toe.

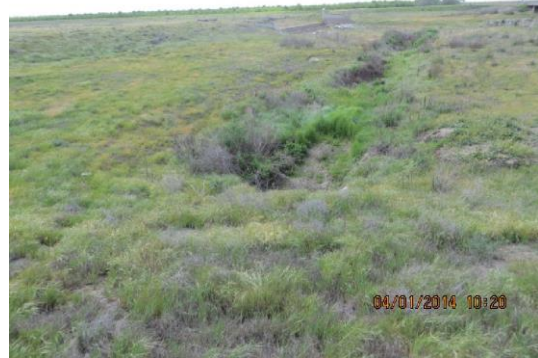
Photo 1 of 3 : UCIP\_SP\_2019\_39648\_59701.jpg

Comment Code						
Inspector Comment						
FS_ID:39648						
DS_ID:19703						
EP_NO: N/A						
Repair Type: Non-Urgent						
Crossing Status: Found						
UCIP Comments: 04/01/2014 Dense vegetation limits the inspector's visibility to identify signs of pipe failure (leaks) along the slopes.						
Recommend removing vegetation along pipe alignment to conduct proper inspection of structure. (DWR UCIP - W. Wylie)						
FIELD_STRUCT_DESC: 30-inch by 30-inch reinforced concrete box gravity drainage culvert through the levee, 13.9 feet below the crown.						
Flap gate on the waterside (WS) end. Concrete headwall on the landside (LS) end. Concrete U-shaped headwall on the WS end.						
[Additional Reference(s): DWR Levee Log, 2002. USACE San Joaquin O&M Manual 601.1, 1967, (HLM 33.72)].						
FS Date: 4/1/2014

Concrete headwall at WS toe.

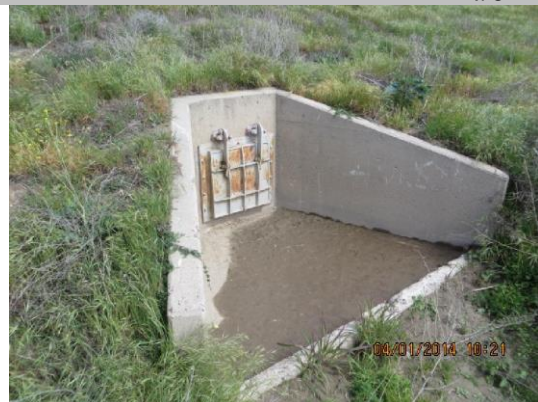
Photo 2 of 3 : UCIP\_SP\_2019\_39648\_59700.jpg

Flapgate on Concrete headwall at WS toe.

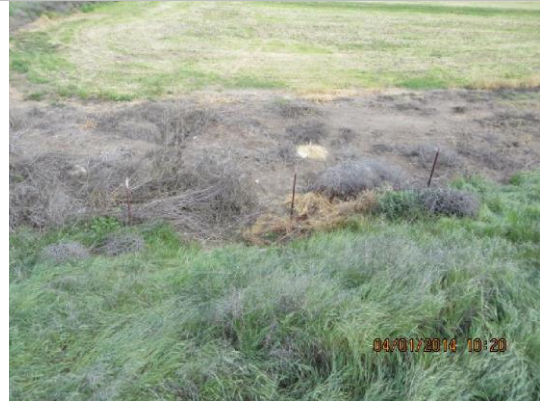
Photo 3 of 3 : UCIP\_SP\_2019\_39648\_59702.jpg

Item	DWR UCIP LMA Responsibility			36.976808 °	36.976808 °	
				-120.382593 °	-120.382593 °	
DWR ID	19703					
Comment Code						
Inspector Comment						
FS_ID:39648						
DS_ID:19703						
EP_NO: N/A						
Repair Type: Non-Urgent						
Crossing Status: Found						
UCIP Comments: 04/01/2014 Dense vegetation limits the inspector's visibility to identify signs of pipe failure (leaks) along the slopes.						
Recommend removing vegetation along pipe alignment to conduct proper inspection of structure. (DWR UCIP - W. Wylie)						
FIELD_STRUCT_DESC: 30-inch by 30-inch reinforced concrete box gravity drainage culvert through the levee, 13.9 feet below the crown.						
Flap gate on the waterside (WS) end. Concrete headwall on the landside (LS) end. Concrete U-shaped headwall on the WS end.						
[Additional Reference(s): DWR Levee Log, 2002. USACE San Joaquin O&M Manual 601.1, 1967, (HLM 33.72)].						
FS Date: 4/1/2014

Concrete headwall at LS toe.

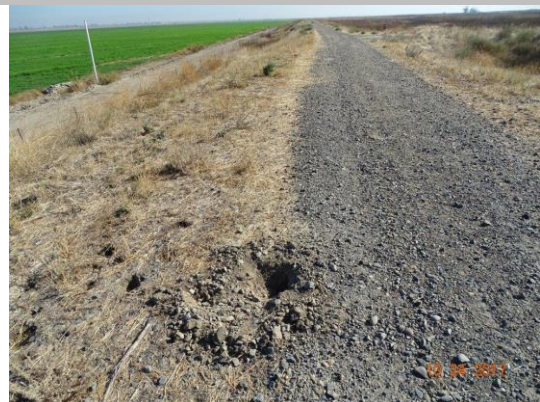
Photo 1 of 1 : SP\_2019\_NA0010\_123\_130\_20190307\_00029.jpg

LM Start	33.82	Rating **	M	Issue No.	130
LM End	33.82	Issue Type +	Ma	Location *	LS
Category	Earthen Levee			GPS Latitude/Longitude	
				Start	End
Item	Animal Control			36.976849 °	36.976849 °
				-120.382393 °	-120.382393 °
DWR ID	DWR_NA0010_05_f_2017_130				
Comment Code					
A3 : No rodents visible, but rodent burrows visible; need to backfill and compact or grout burrows.					
Inspector Comment

Looking east at the landside shoulder.

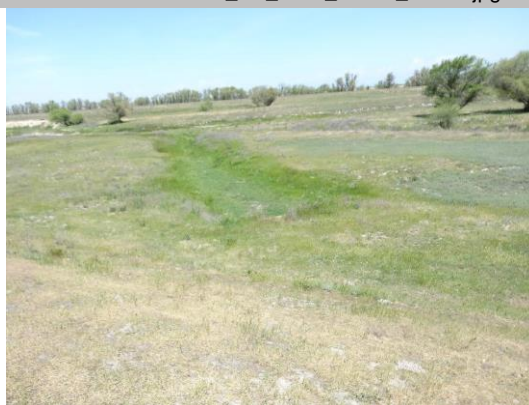
Photo 1 of 3 : UCIP\_SP\_2019\_36565\_66346.jpg

LM Start	0.78	Rating **	M	Issue No.	1213
LM End	0.78	Issue Type +	Ma	Location *	
Category	Supplemental			GPS Latitude/Longitude	
				Start	End
Item	DWR UCIP LMA Responsibility			37.270460 °	37.270460 °
				-120.814290 °	-120.814290 °
DWR ID	19816				
Comment Code					
Inspector Comment					
FS_ID:36565 DS_ID:19816 EP_NO: N/A Repair Type: Non-Urgent Crossing Status: Found UCIP Comments: 04/18/2014 Landward side blocked--need to contact owner to determine status of crossing. (DWR UCIP - O. Magana) FIELD_STRUCT_DESC: 24-inch corrugated metal gravity drainage pipe through the levee, 16.2 feet below the crown. Flap gate on the waterside (WS) end. Concrete U-shaped headwall on each end. [Additional Reference(s): DWR Levee Log, 2002. USACE San Joaquin O&M Manual 601.1, 1967, (HLM 0.86)]. FS Date: 4/18/2014

Overview of waterward side.

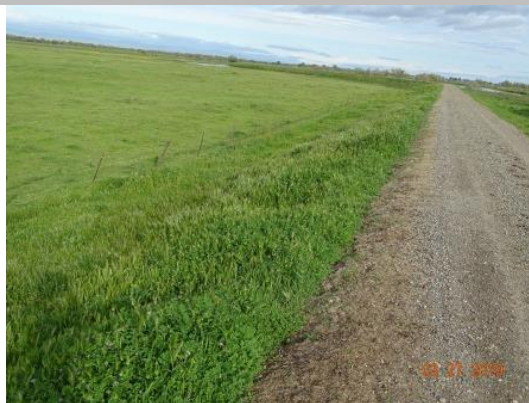
Photo 1 of 1 : SP\_2019\_NA0010\_124\_62\_20190418\_00190.jpg

LM Start	0.97	Rating **	M	Issue No.	62
LM End	1.90	Issue Type +	Ma	Location *	LS
Category	Earthen Levee			GPS Latitude/Longitude	
				Start	End
Item	Vegetation			37.268366 °	37.259076 °
				-120.812706 °	-120.802346 °
DWR ID	DWR_NA0010_06_s_2019_62				
Comment Code					
V1 : Control annual grass and weeds on the levee slopes and easements.					
Inspector Comment

View of landside slope looking upstream. (Spring 2019)

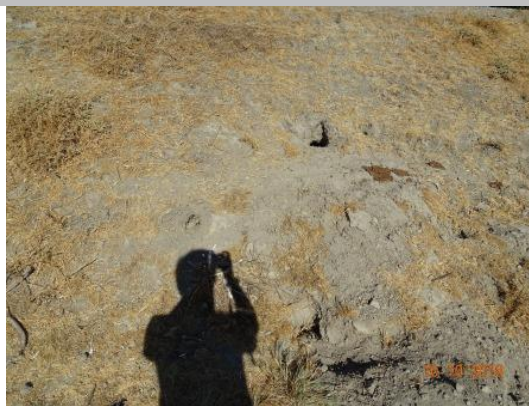
Photo 1 of 2 : SP\_2019\_NA0010\_124\_93\_20190307\_00040.jpg

LM Start	1.18	Rating **	U	Issue No.	93
LM End	1.18	Issue Type +	Ma	Location *	LS
Category	Earthen Levee			GPS Latitude/Longitude	
				Start	End
Item	Animal Control			37.267101 °	37.267101 °
				-120.809603 °	-120.809603 °
DWR ID	DWR_NA0010_06_f_2018_93				
Comment Code					
A3 : No rodents visible, but rodent burrows visible; need to backfill and compact or grout burrows.					
Inspector Comment					
Several rodent burrows including large burrows were observed at this location.

View of landside slope. (Fall 2018)

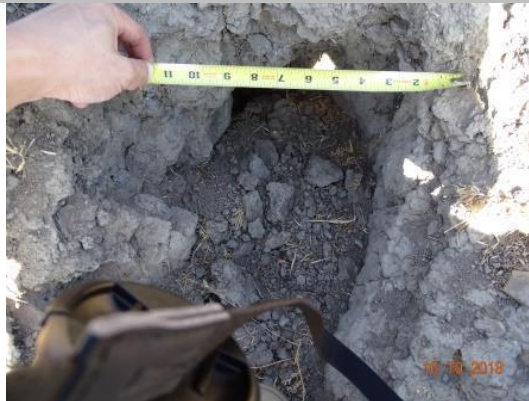
Photo 2 of 2 : SP\_2019\_NA0010\_124\_93\_20190307\_00041.jpg

View and measurement of large rodent hole found at this location. (Fall 2018)

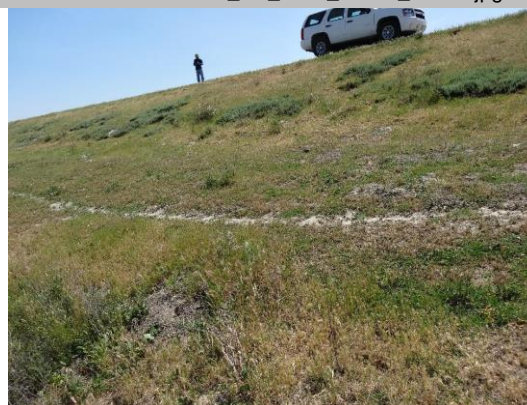
Photo 1 of 3 : UCIP\_SP\_2019\_36566\_66348.jpg

LM Start	1.87	Rating **	M	Issue No.	1214
LM End	1.87	Issue Type +	Ma	Location *	
Category	Supplemental			GPS Latitude/Longitude	
				Start	End
Item	DWR UCIP LMA Responsibility			37.259312 °	37.259312 °
				-120.802863 °	-120.802863 °
DWR ID	19817				
Comment Code					
Inspector Comment					
FS_ID:36566 DS_ID:19817 EP_NO: N/A Repair Type: Non-Urgent Crossing Status: Found UCIP Comments: 04/18/2014 No access was available to landward side due to fence. Recommend removing some of the vegetation on waterward toe. (DWR UCIP - O. Magana) FIELD_STRUCT_DESC: 24-inch corrugated metal gravity drainage pipe through the levee, 13.5 feet below the crown. Flap gate on the waterside (WS) end. Concrete headwall on each end. [Additional Reference(s): DWR Levee Log, 2002. USACE San Joaquin O&M Manual 601.1, 1967, (HLM 1.95)]. FS Date: 4/18/2014

View of waterward side.

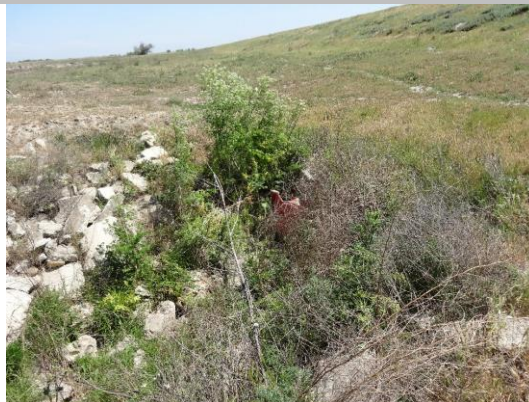
Photo 3 of 3 : UCIP\_SP\_2019\_36566\_66349.jpg

LM Start	1.87	Rating **	M	Issue No.	1214 (cont)	
LM End	1.87	Issue Type +	Ma	Location *		
Category	Supplemental			GPS Latitude/Longitude		
				Start		End
Item	DWR UCIP LMA Responsibility			37.259312 °	37.259312 °	
				-120.802863 °	-120.802863 °	
DWR ID	19817					
Comment Code						
Inspector Comment						
FS_ID:36566 DS_ID:19817 EP_NO: N/A Repair Type: Non-Urgent Crossing Status: Found UCIP Comments: 04/18/2014 No access was available to landward side due to fence. Recommend removing some of the vegetation on waterward toe. (DWR UCIP - O. Magana) FIELD_STRUCT_DESC: 24-inch corrugated metal gravity drainage pipe through the levee, 13.5 feet below the crown. Flap gate on the waterside (WS) end. Concrete headwall on each end. [Additional Reference(s): DWR Levee Log, 2002. USACE San Joaquin O&M Manual 601.1, 1967, (HLM 1.95)]. FS Date: 4/18/2014

Flap gate visible on waterward side.

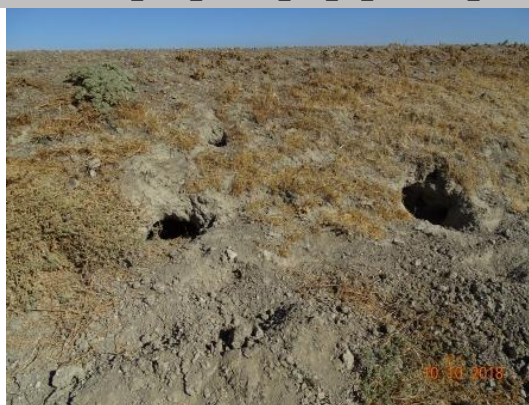
Photo 1 of 2 : SP\_2019\_NA0010\_124\_92\_20190307\_00038.jpg

LM Start	2.42	Rating **	U	Issue No.	92
LM End	2.42	Issue Type +	Ma	Location *	LS
Category	Earthen Levee			GPS Latitude/Longitude	
				Start	End
Item	Animal Control			37.254519 °	37.254519 °
				-120.795141 °	-120.795141 °
DWR ID	DWR_NA0010_06_f_2018_92				
Comment Code					
A3 : No rodents visible, but rodent burrows visible; need to backfill and compact or grout burrows.					
Inspector Comment

View of large rodent holes in landside slope. (Fall 2018)

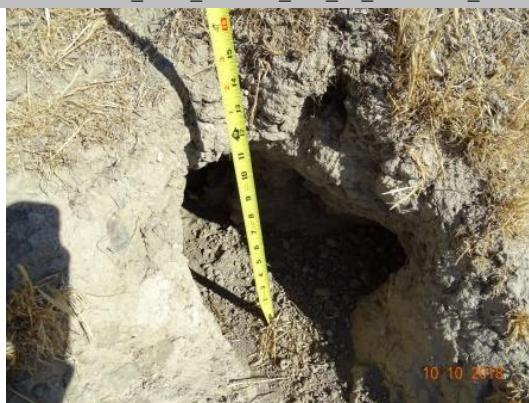
Photo 2 of 2 : SP\_2019\_NA0010\_124\_92\_20190307\_00039.jpg

Measurement of large burrow. (Fall 2018)

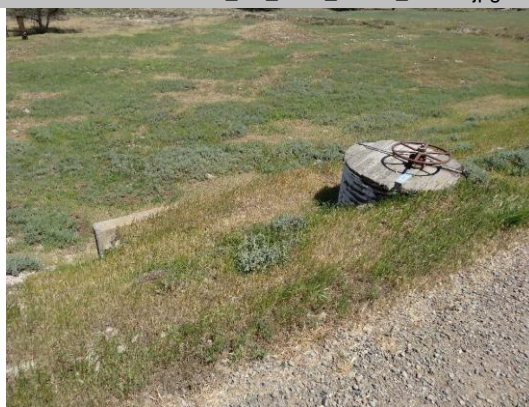
Photo 2 of 3 : UCIP\_SP\_2019\_39464\_66357.jpg

View of waterward side.

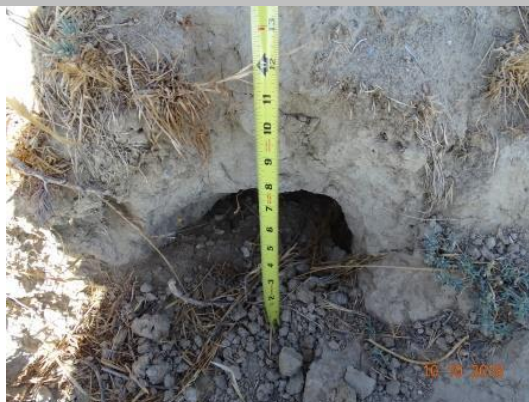
Photo 1 of 1 : SP\_2019\_NA0010\_124\_76\_20190307\_00024.jpg

LM Start	2.54	Rating **	M	Issue No.	76
LM End	2.54	Issue Type +	Ma	Location *	LS
Category	Earthen Levee			GPS Latitude/Longitude	
				Start	End
Item	Animal Control			37.252874 °	37.252874 °
				-120.794192 °	-120.794192 °
DWR ID	DWR_NA0010_06_f_2016_76				
Comment Code					
A3 : No rodents visible, but rodent burrows visible; need to backfill and compact or grout burrows.					
Inspector Comment					
There are several rodent burrows in the landside slope at this location.

Representative view of rodent burrow found at this section. (Fall 2018)

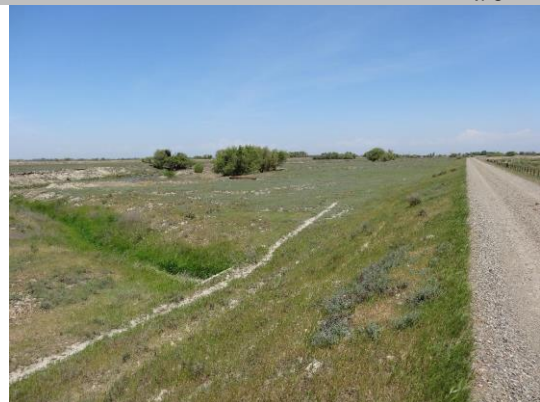
Photo 1 of 3 : UCIP\_SP\_2019\_36569\_66369.jpg

Comment Code					
Inspector Comment					
FS_ID:36569					
DS_ID:19820					
EP_NO: N/A					
Repair Type: Non-Urgent					
Crossing Status: Found					
UCIP Comments: 04/18/2014 Dense vegetation limits the inspector's visibility to identify signs of pipe condition on landward toe--headwall blocked by dense vegetation. Recommend removing vegetation from landward toe. (DWR UCIP - O. Magana)					
FIELD_STRUCT_DESC: 24-inch corrugated metal gravity drainage pipe through the levee, 10.5 feet below the crown. Flap gate on the waterside (WS) end. Concrete headwall on each end. [Additional Reference(s): DWR Levee Log, 2002. USACE San Joaquin O&M Manual 601.1, 1967, (HLM 2.85)].					
FS Date: 4/18/2014

View of waterward side.

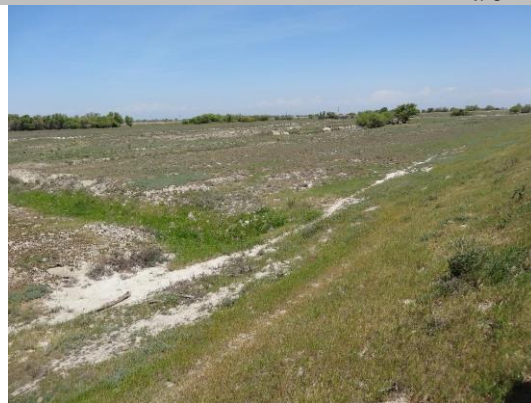
Photo 1 of 3 : UCIP\_SP\_2019\_36583\_66381.jpg

Comment Code					
Inspector Comment					
FS_ID:36583					
DS_ID:19821					
EP_NO: N/A					
Repair Type: Non-Urgent					
Crossing Status: Found					
UCIP Comments: 04/18/2014 Dense vegetation limits the inspector's visibility to identify signs of pipe condition on landward toe--headwall blocked by dense vegetation. Recommend removing vegetation from landward toe. (DWR UCIP - O. Magana)					
FIELD_STRUCT_DESC: 24-inch corrugated metal gravity drainage pipe through the levee, 11.2 feet below the crown. Flap gate on the waterside (WS) end. Concrete headwall on each end. [Additional Reference(s): DWR Levee Log, 2002. USACE San Joaquin O&M Manual 601.1, 1967, (HLM 3.09)].					
FS Date: 4/18/2014

View of waterward side.

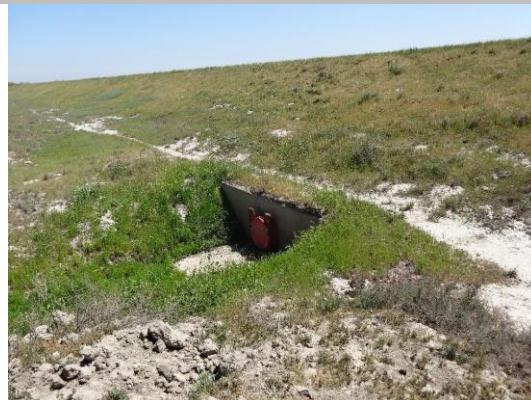
Photo 2 of 3 : UCIP\_SP\_2019\_36583\_66380.jpg

Flap gate and concrete headwall visible on waterward side.

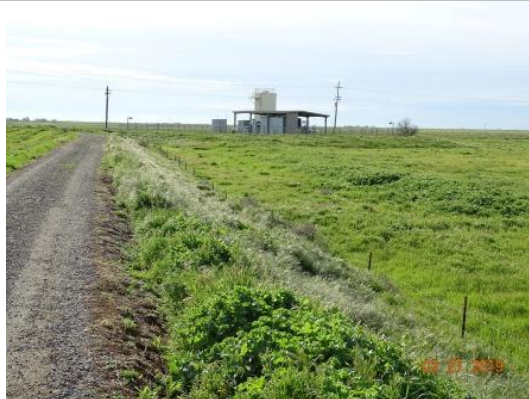
Photo 1 of 1 : SP\_2019\_NA0010\_124\_71\_20190418\_00192.jpg

LM Start	3.33	Rating **	M	Issue No.	71
LM End	3.85	Issue Type +	Ma	Location *	LS
Category	Earthen Levee			GPS Latitude/Longitude	
				Start	End
Item	Vegetation			37.252512 °	37.251096 °
				-120.780643 °	-120.771711 °
DWR ID	DWR_NA0010_06_s_2019_71				
Comment Code					
V1 : Control annual grass and weeds on the levee slopes and easements.					
Inspector Comment

View of landside slope looking upstream. (Spring 2019)

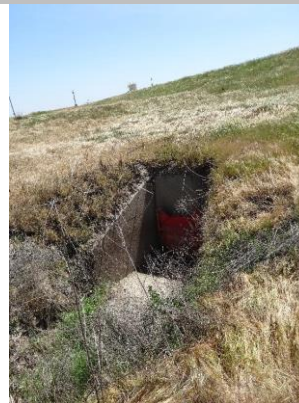
Photo 2 of 3 : UCIP\_SP\_2019\_36585\_66390.jpg

Flap gate and concrete headwall visible on waterward side.

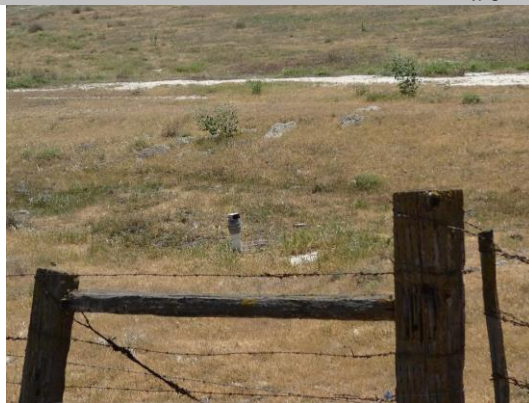
Photo 3 of 3 : UCIP\_SP\_2019\_36585\_66391.jpg

Comment Code						
Inspector Comment						
FS_ID:36585 DS_ID:19823 EP_NO: N/A Repair Type: Non-Urgent Crossing Status: Found UCIP Comments: 04/18/2014 Alignment of crossing unknown--altered crossing. No headwall found on landward side only siphon breaker found a short distance from landward toe. Tall grass observed on waterward slope and some burrow activity also noticed. Need to contact owner to determine alignment of crossing and status of crossing. (DWR UCIP - O. Magana) FIELD_STRUCT_DESC: 36-inch corrugated metal gravity drainage pipe through the levee, 15.7 feet below the crown. Flap gate on the waterside (WS) end. Concrete U-shaped headwall on each end. Bench mark (BM) stamped 9770-152 on top of the WS headwall. [Additional Reference(s): DWR Levee Log, 2002. USACE San Joaquin O&M Manual 601.1, 1967, (HLM 3.43)]. FS Date: 4/18/2014

View of landward side. No signs of concrete headwall only siphon breaker visible on landward side.

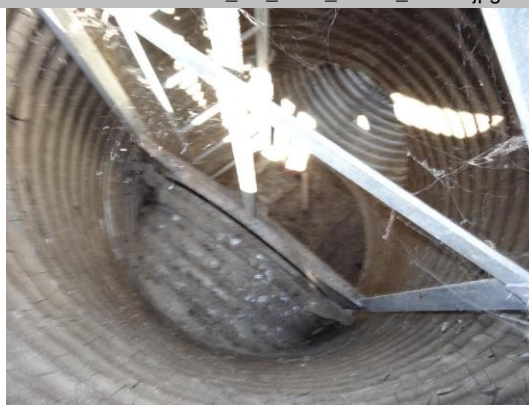
Photo 2 of 3 : UCIP\_SP\_2019\_39465\_66395.jpg

Comment Code						
Inspector Comment						
FS_ID:39465 DS_ID:19825 EP_NO: N/A Repair Type: Non-Urgent Crossing Status: Found UCIP Comments: 04/18/2014 Sediment buildup inside pipe visible from landward side. Excess soil is also present on landward toe partially blocking concrete headwall and inlet. Recommend removing soil from landward toe and clear buildup inside. (DWR UCIP - O. Magana) FIELD_STRUCT_DESC: 36-inch corrugated metal gravity drainage pipe through the levee, 6.8 feet below the crown. Slide gate in a 48-inch corrugated metal pipe (CMP) riser on the waterside (WS) slope. Concrete headwall on each end. Pipe connects to a 30-inch steel drainage pipe on the WS. Drainage pipe extends to the pump on the WS on a support platform in the channel. (Extension drainage pipe and pump installed under Permit No. 12527, 1979 - Joseph Gallo). [Additional Reference(s): DWR Levee Log, 2002. USACE San Joaquin O&M Manual 601.1, 1967, (HLM 3.54)]. FS Date: 4/18/2014

Inside view of cmp riser located on waterward slope.

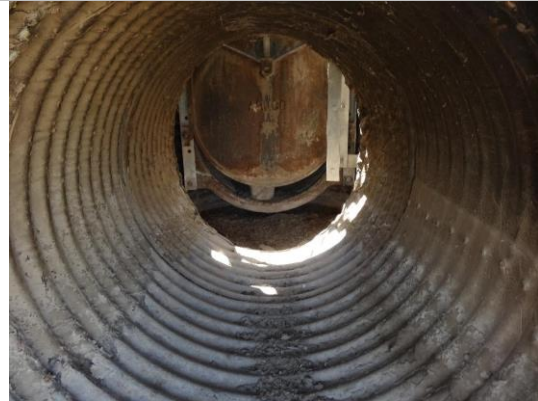
Photo 3 of 3 : UCIP\_SP\_2019\_39465\_66397.jpg

Comment Code						
Inspector Comment						
FS_ID:39465 DS_ID:19825 EP_NO: N/A Repair Type: Non-Urgent Crossing Status: Found UCIP Comments: 04/18/2014 Sediment buildup inside pipe visible from landward side. Excess soil is also present on landward toe partially blocking concrete headwall and inlet. Recommend removing soil from landward toe and clear buildup inside. (DWR UCIP - O. Magana) FIELD_STRUCT_DESC: 36-inch corrugated metal gravity drainage pipe through the levee, 6.8 feet below the crown. Slide gate in a 48-inch corrugated metal pipe (CMP) riser on the waterside (WS) slope. Concrete headwall on each end. Pipe connects to a 30-inch steel drainage pipe on the WS. Drainage pipe extends to the pump on the WS on a support platform in the channel. (Extension drainage pipe and pump installed under Permit No. 12527, 1979 - Joseph Gallo). [Additional Reference(s): DWR Levee Log, 2002. USACE San Joaquin O&M Manual 601.1, 1967, (HLM 3.54)]. FS Date: 4/18/2014

Inside view of pipe from waterward side.

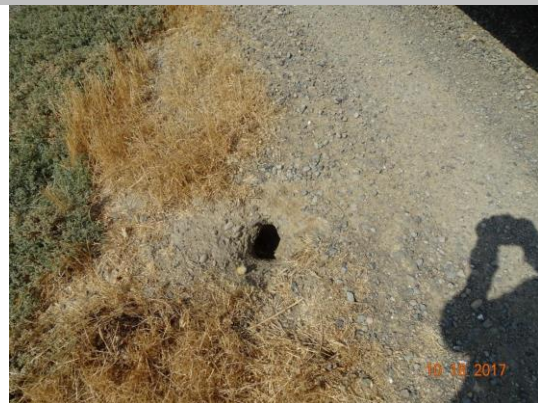
Photo 1 of 1 : SP\_2019\_NA0010\_124\_67\_20190307\_00017.jpg

LM Start	3.49	Rating **	M	Issue No.	67
LM End	3.49	Issue Type +	Ma	Location *	LS
Category	Earthen Levee			GPS Latitude/Longitude	
				Start	End
Item	Animal Control			37.251602 °	37.251602 °
				-120.778118 °	-120.778118 °
DWR ID	DWR_NA0010_06_f_2017_67				
Comment Code					
A3 : No rodents visible, but rodent burrows visible; need to backfill and compact or grout burrows.					
Inspector Comment

Looking east at the landside slope.

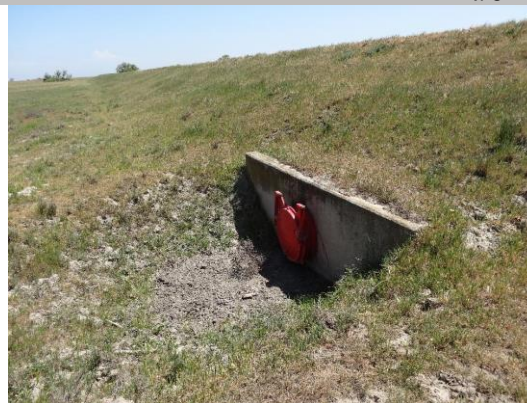
Photo 3 of 3 : UCIP\_SP\_2019\_39466\_66411.jpg

Comment Code						
Inspector Comment						
FS_ID:39466 DS_ID:19826 EP_NO: N/A Repair Type: Non-Urgent Crossing Status: Found UCIP Comments: 04/18/2014 Sediment buildup inside crossing and is visible from landward side. Recommend clearing sediment buildup inside pipe and check wall integrity to determine condition. (DWR UCIP - O. Magana) FIELD_STRUCT_DESC: 24-inch corrugated metal gravity drainage pipe through the levee, 7 feet below the crown. Flap gate on the waterside (WS) end. Concrete headwall on each end. [Additional Reference(s): DWR Levee Log, 2002. USACE San Joaquin O&M Manual 601.1, 1967, (HLM 3.77)]. FS Date: 4/18/2014

View of flap gate visible on waterward side.

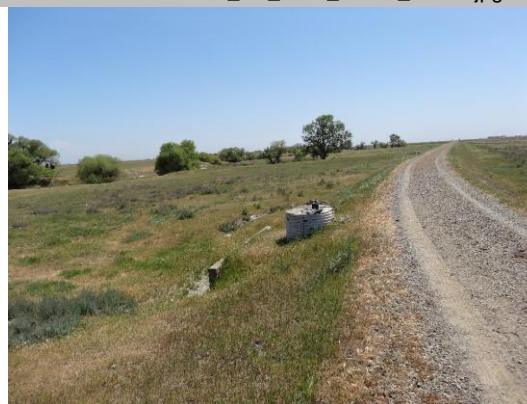
Photo 1 of 3 : UCIP\_SP\_2019\_39467\_66407.jpg

Comment Code						
Inspector Comment						
FS_ID:39467 DS_ID:19827 EP_NO: N/A Repair Type: Non-Urgent Crossing Status: Found UCIP Comments: 04/18/2014 Sediment buildup inside crossing and is visible from landward side. Recommend clearing sediment buildup inside pipe and check wall integrity to determine condition. (DWR UCIP - O. Magana) FIELD_STRUCT_DESC: 36-inch corrugated metal gravity drainage pipe through the levee, 6.7 feet below the crown. Slide gate in a 48-inch corrugated metal pipe (CMP) riser on the waterside (WS) slope. [Additional Reference(s): DWR Levee Log, 2002. USACE San Joaquin O&M Manual 601.1, 1967, (HLM 3.97)]. FS Date: 4/18/2014

View of waterward side.

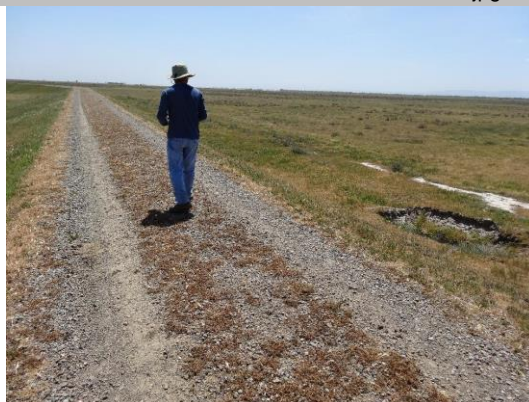
Photo 2 of 3 : UCIP\_SP\_2019\_36606\_66417.jpg

Comment Code						
Inspector Comment						
FS_ID:36606 DS_ID:19828 EP_NO: N/A Repair Type: Non-Urgent Crossing Status: Found UCIP Comments: 04/18/2014 Dense vegetation limits the inspector's visibility to identify signs of pipe condition on landward toe--headwall blocked by dense vegetation. Recommend removing vegetation from landward toe. (DWR UCIP - O. Magana) FIELD_STRUCT_DESC: 24-inch corrugated metal gravity drainage pipe through the levee, 10.8 feet below the crown. Flap gate on the waterside (WS) end. Concrete headwall on each end. [Additional Reference(s): DWR Levee Log, 2002. USACE San Joaquin O&M Manual 601.1, 1967, (HLM 4.17)]. FS Date: 4/18/2014

Overview of levee crown at crossing.

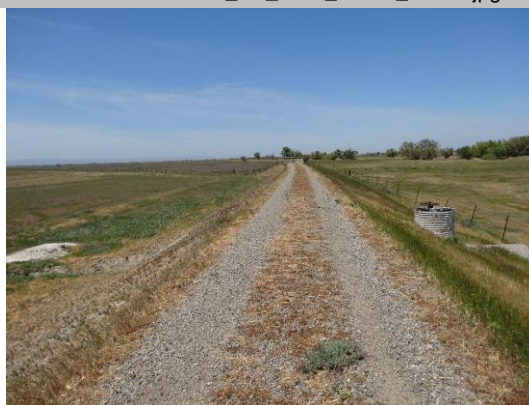
Photo 1 of 3 : UCIP\_SP\_2019\_39468\_66425.jpg

Comment Code					
Inspector Comment					
FS_ID:39468 DS_ID:19830 EP_NO: N/A Repair Type: Non-Urgent Crossing Status: Found UCIP Comments: 04/18/2014 Sediment buildup inside crossing visible from landward side. Recommend clearing sediment buildup inside pipe and check wall integrity to determine condition. (DWR UCIP - O. Magana) FIELD_STRUCT_DESC: 36-inch corrugated metal gravity drainage pipe through the levee, 6.9 feet below the crown. Slide gate in a 48-inch corrugated metal pipe (CMP) riser on the waterside (WS) slope. Concrete headwall on the landside (LS) end. Concrete saddle and apron on the WS end. [Additional Reference(s): DWR Levee Log, 2002. USACE San Joaquin O&M Manual 601.1, 1967, (HLM 4.70)]. FS Date: 4/18/2014

Overview of levee crown at crossing.

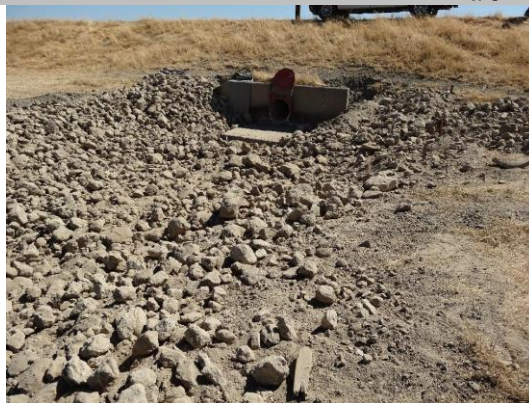
Photo 2 of 3 : UCIP\_SP\_2019\_51312\_75488.jpg

Comment Code					
Inspector Comment					
FS_ID:51312 DS_ID:19865 EP_NO: N/A Repair Type: No Action Needed Crossing Status: Found UCIP Comments: 7/19/2016 Site has been repaired on WS and LS (see photos below). (DWR UCIP - omagana)5/26/2016 Erosion is undermining the WS headwall of drainage structure (photos of WS headwall provided by DWR Inspector R. Willoughby). Potential pipe failure at the outlet just behind headwall, recommend completing internal wall integrity of pipe length through levee to determine extent of damage to pipe. (DWR UCIP - omagana)4/18/2014 Need to contact owner. Sediment buildup in pipe visible on landside--recommend clearing. (DWR UCIP - omagana) FIELD_STRUCT_DESC: 24-inch corrugated metal gravity drainage pipe through the levee, 9 feet below the crown. Flap gate on the waterside (WS) end. Concrete headwall on each end. [Additional Reference(s): DWR Levee Log, 2002. USACE San Joaquin O&M Manual 601.1, 1967, (HLM 6.06)]. FS Date: 7/19/2016

WS drainage path protected by rip rap.

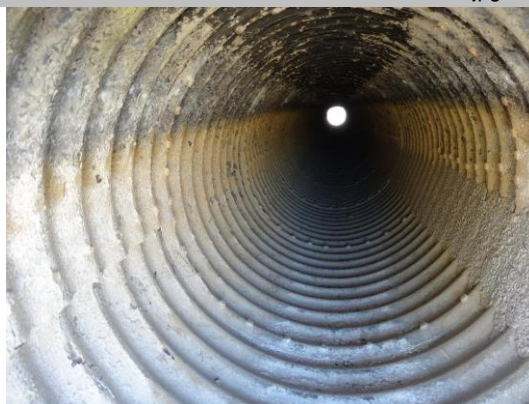
Photo 3 of 3 : UCIP\_SP\_2019\_51312\_75489.jpg

Inside view of pipe from WS.

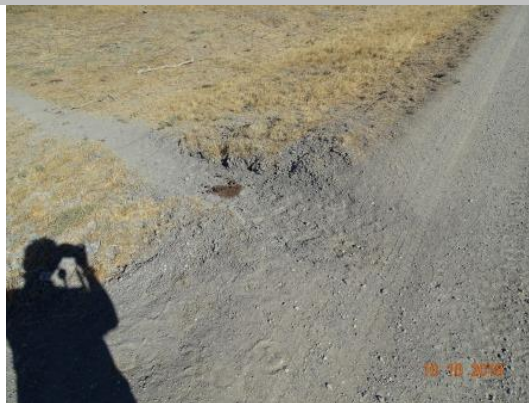
Photo 1 of 1 : SP\_2019\_NA0010\_124\_85\_20190307\_00033.jpg

LM Start	6.09	Rating **	M	Issue No.	85
LM End	6.09	Issue Type +	Ma	Location *	WS
Category	Earthen Levee			GPS Latitude/Longitude	
				Start	End
Item	Slope Stability			37.235572 °	37.235572 °
				-120.738002 °	-120.738002 °
DWR ID	DWR_NA0010_06_f_2018_85				
Comment Code					
S2 : Repair the levee slope damaged by foot traffic and prevent access where possible.					
Inspector Comment					
Livestock damage to slope and shoulder of levee.

View of livestock damage on waterside slope. (Fall 2018)

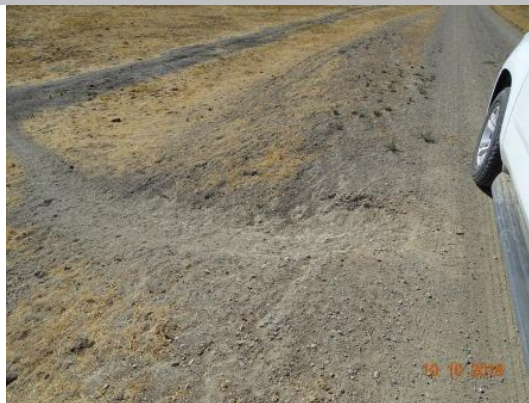
Photo 1 of 1 : SP\_2019\_NA0010\_124\_84\_20190307\_00032.jpg

LM Start	6.10	Rating **	M	Issue No.	84
LM End	6.10	Issue Type +	Ma	Location *	LS
Category	Earthen Levee			GPS Latitude/Longitude	
				Start	End
Item	Slope Stability			37.235570 °	37.235570 °
				-120.737998 °	-120.737998 °
DWR ID	DWR_NA0010_06_f_2018_84				
Comment Code					
S2 : Repair the levee slope damaged by foot traffic and prevent access where possible.					
Inspector Comment					
Damage to slope and crown from livestock.

Erosion to slope and into crown from livestock. (Fall 2018)

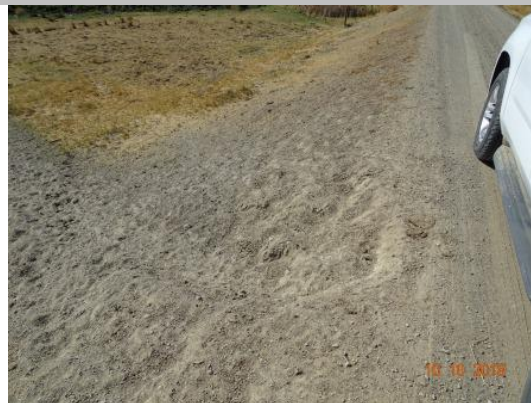
Photo 1 of 1 : SP\_2019\_NA0010\_124\_79\_20190307\_00027.jpg

LM Start	6.92	Rating **	M	Issue No.	79
LM End	6.92	Issue Type +	Ma	Location *	LS
Category	Earthen Levee			GPS Latitude/Longitude	
				Start	End
Item	Slope Stability			37.228054 °	37.228054 °
				-120.727428 °	-120.727428 °
DWR ID	DWR_NA0010_06_f_2018_79				
Comment Code					
S2 : Repair the levee slope damaged by foot traffic and prevent access where possible.					
Inspector Comment					
There is livestock damage to slope and shoulder of levee.

Damage to slope and shoulder from livestock. (Fall 2018)

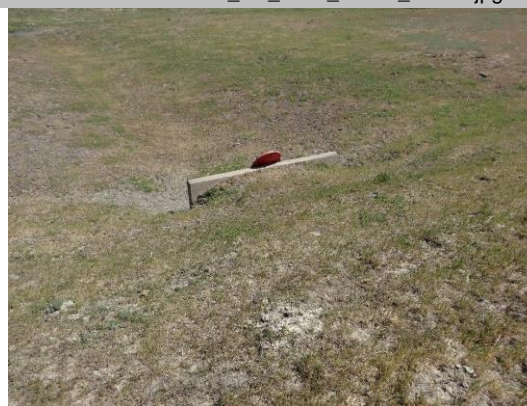
Photo 1 of 3 : UCIP\_SP\_2019\_39471\_61650.jpg

LM Start	7.21	Rating **	M	Issue No.	1235
LM End	7.21	Issue Type +	Ma	Location *	
Category	Supplemental			GPS Latitude/Longitude	
				Start	End
Item	DWR UCIP LMA Responsibility			37.226102°	37.226102°
				-120.722739°	-120.722739°
DWR ID	19868				
Comment Code					
Inspector Comment					
FS_ID:39471 DS_ID:19868 EP_NO: N/A Repair Type: Non-Urgent Crossing Status: Found UCIP Comments: 04/18/2014 Need to contact owner. Clear animal from waterward side. Some sediment buildup in pipe visible landward side--recommend clearing. (DWR UCIP - O. Magana) FIELD_STRUCT_DESC: 24-inch corrugated metal gravity drainage pipe through the levee, 10.6 feet below the crown. Flap gate on the waterside (WS) end. Concrete headwall on each end. [Additional Reference(s): DWR Levee Log, 2002. USACE San Joaquin O&M Manual 601.1, 1967, (HLM 7.29)]. FS Date: 4/18/2014

View of waterward side.

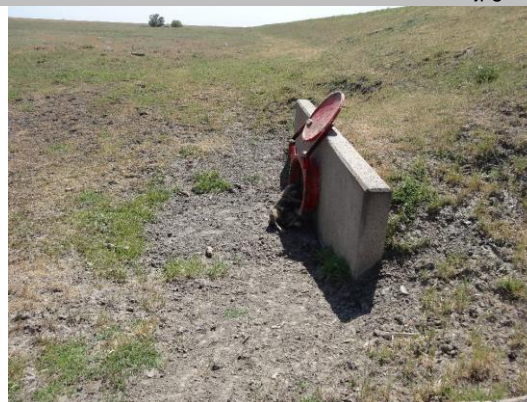
Photo 2 of 3 : UCIP\_SP\_2019\_39471\_61649.jpg

Concrete headwall and flap gate visible on waterward side. Dead animal inside pipe.

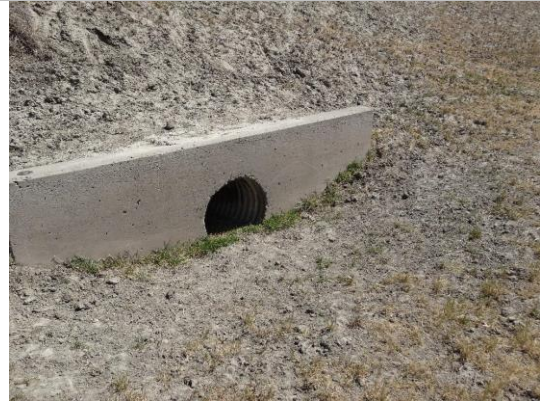
Photo 3 of 3 : UCIP\_SP\_2019\_39471\_61648.jpg

LM Start	7.21	Rating **	M	Issue No.	1235 (cont)
LM End	7.21	Issue Type +	Ma	Location *	
Category	Supplemental			GPS Latitude/Longitude	
				Start	End
Item	DWR UCIP LMA Responsibility			37.226102 °	37.226102 °
				-120.722739 °	-120.722739 °
DWR ID	19868				
Comment Code					
Inspector Comment					
FS_ID:39471 DS_ID:19868 EP_NO: N/A Repair Type: Non-Urgent Crossing Status: Found UCIP Comments: 04/18/2014 Need to contact owner. Clear animal from waterward side. Some sediment buildup in pipe visible landward side--recommend clearing. (DWR UCIP - O. Magana) FIELD_STRUCT_DESC: 24-inch corrugated metal gravity drainage pipe through the levee, 10.6 feet below the crown. Flap gate on the waterside (WS) end. Concrete headwall on each end. [Additional Reference(s): DWR Levee Log, 2002. USACE San Joaquin O&M Manual 601.1, 1967, (HLM 7.29)]. FS Date: 4/18/2014

View of landward side.

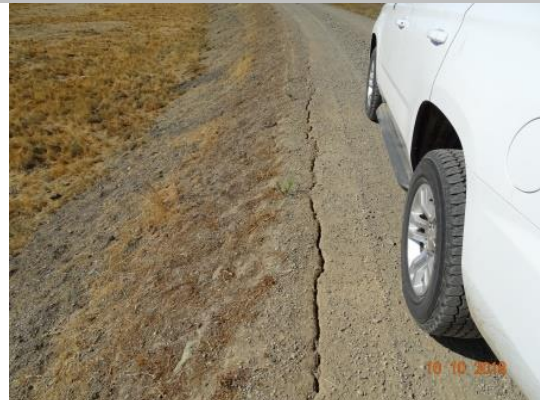
Photo 1 of 2 : SP\_2019\_NA0010\_124\_78\_20190307\_00025.jpg

LM Start	7.56	Rating **	A/W	Issue No.	78
LM End	7.56	Issue Type +	Ma	Location *	CR
Category	Earthen Levee			GPS Latitude/Longitude	
				Start	End
Item	Cracking			37.224113 °	37.224113 °
				-120.716887 °	-120.716887 °
DWR ID	DWR_NA0010_06_f_2018_78				
Comment Code					
CR1 : Monitor and have inspected by geotechnical engineer.					
Inspector Comment					
There is cracking along the landside shoulder of the crown.

View of crack along crown looking downstream.

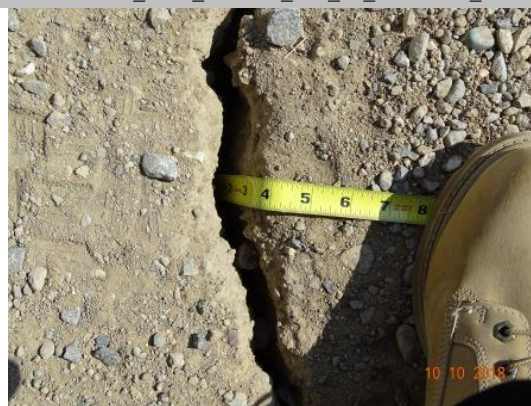
Photo 2 of 2 : SP\_2019\_NA0010\_124\_78\_20190307\_00026.jpg

LM Start	7.56	Rating **	A/W	Issue No.	78 (cont)	
LM End	7.56	Issue Type +	Ma	Location *	CR	
Category	Earthen Levee			GPS Latitude/Longitude		
				Start		End
Item	Cracking			37.224113 °		37.224113 °
				-120.716887 °		-120.716887 °
DWR ID	DWR_NA0010_06_f_2018_78					
Comment Code						
CR1 : Monitor and have inspected by geotechnical engineer.						
Inspector Comment						
There is cracking along the landside shoulder of the crown.

View of average depth of crack. (Fall 2018)

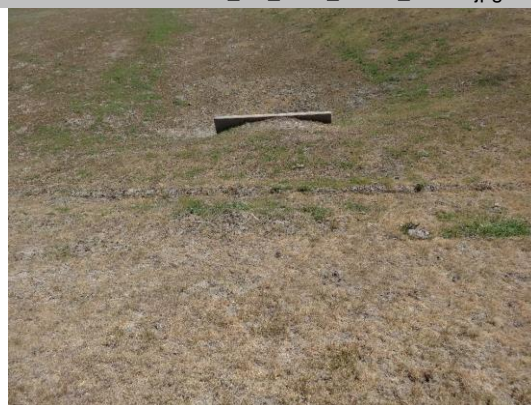
Photo 1 of 3 : UCIP\_SP\_2019\_39472\_66462.jpg

LM Start	7.66	Rating **	M	Issue No.	1236
LM End	7.66	Issue Type +	Ma	Location *	
Category	Supplemental			GPS Latitude/Longitude	
				Start	End
Item	DWR UCIP LMA Responsibility			37.222743 °	37.222743 °
				-120.716416 °	-120.716416 °
DWR ID	19869				
Comment Code					
Inspector Comment					
FS_ID:39472 DS_ID:19869 EP_NO: N/A Repair Type: Non-Urgent Crossing Status: Found UCIP Comments: 04/18/2014 Some sediment buildup in pipe visible on landward side--recommend clearing. (DWR UCIP - O. Magana) FIELD_STRUCT_DESC: 24-inch corrugated metal gravity drainage pipe through the levee, 11.8 feet below the crown. Flap gate on the waterside (WS) end. Concrete headwall on each end. Skewed crossing. [Additional Reference(s): DWR Levee Log, 2002. USACE San Joaquin O&M Manual 601.1, 1967, (HLM 7.74)]. FS Date: 4/18/2014

View of waterward side.

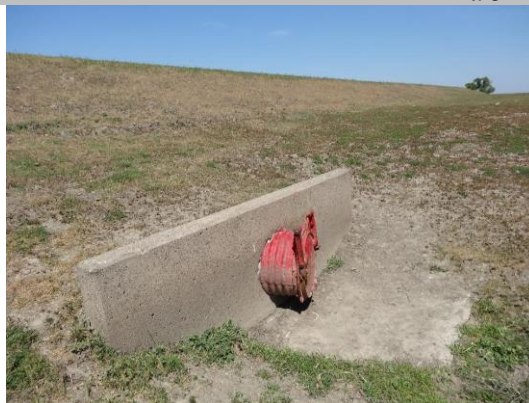
Photo 2 of 3 : UCIP\_SP\_2019\_39472\_66461.jpg

LM Start	7.66	Rating **	M	Issue No.	1236 (cont)	
LM End	7.66	Issue Type +	Ma	Location *		
Category	Supplemental			GPS Latitude/Longitude		
				Start		End
Item	DWR UCIP LMA Responsibility			37.222743 °		37.222743 °
				-120.716416 °		-120.716416 °
DWR ID	19869					
Comment Code						
Inspector Comment						
FS_ID:39472 DS_ID:19869 EP_NO: N/A Repair Type: Non-Urgent Crossing Status: Found UCIP Comments: 04/18/2014 Some sediment buildup in pipe visible on landward side--recommend clearing. (DWR UCIP - O. Magana) FIELD_STRUCT_DESC: 24-inch corrugated metal gravity drainage pipe through the levee, 11.8 feet below the crown. Flap gate on the waterside (WS) end. Concrete headwall on each end. Skewed crossing. [Additional Reference(s): DWR Levee Log, 2002. USACE San Joaquin O&M Manual 601.1, 1967, (HLM 7.74)]. FS Date: 4/18/2014

Pipe crosses levee at an angle.

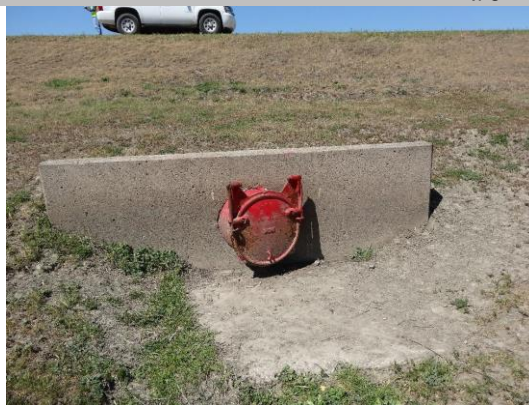
Photo 3 of 3 : UCIP\_SP\_2019\_39472\_66460.jpg

Concrete headwall and flap gate visible on waterward side.

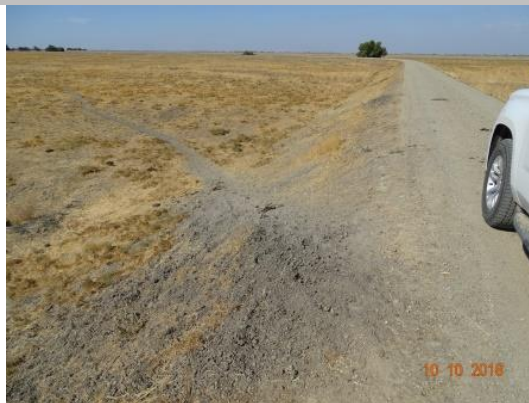
Photo 1 of 1 : SP\_2019\_NA0010\_124\_74\_20190307\_00023.jpg

LM Start	7.66	Rating **	M	Issue No.	74
LM End	7.66	Issue Type +	Ma	Location *	LS
Category	Earthen Levee			GPS Latitude/Longitude	
				Start	End
Item	Slope Stability			37.222689°	37.222689°
				-120.716400°	-120.716400°
DWR ID	DWR_NA0010_06_f_2018_74				
Comment Code					
S2 : Repair the levee slope damaged by foot traffic and prevent access where possible.					
Inspector Comment					
Damage to levee slope from livestock access.

Slope damage from livestock. (Fall 2018)

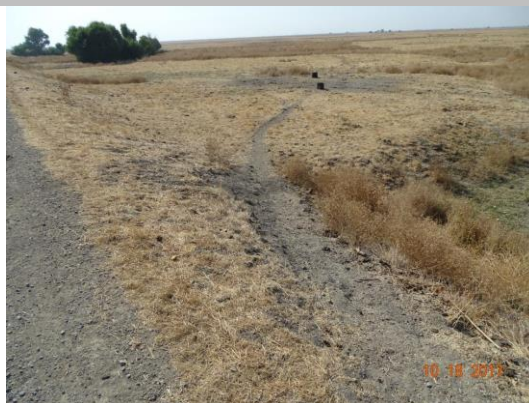
Photo 1 of 1 : SP\_2019\_NA0010\_124\_65\_20190307\_00015.jpg

LM Start	8.08	Rating **	M	Issue No.	65
LM End	8.08	Issue Type +	Ma	Location *	LS
Category	Earthen Levee			GPS Latitude/Longitude	
				Start	End
Item	Slope Stability			37.217199°	37.217199°
				-120.713374°	-120.713374°
DWR ID	DWR_NA0010_06_f_2017_65				
Comment Code					
S2 : Repair the levee slope damaged by foot traffic and prevent access where possible.					
Inspector Comment					
Livestock damage to levee slope.

Looking southwest at the landside slope.

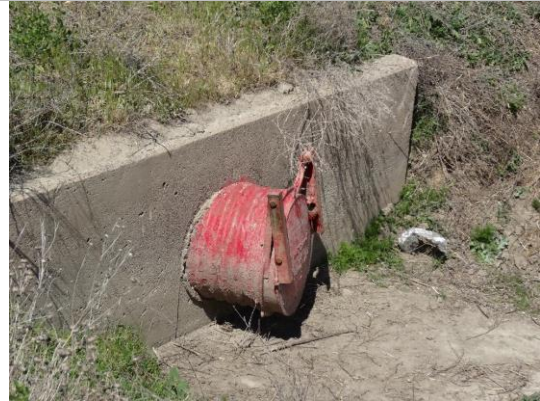
Photo 3 of 3 : UCIP\_SP\_2019\_39473\_61672.jpg

LM Start	8.13	Rating **	M	Issue No.	1237 (cont)	
LM End	8.13	Issue Type +	Ma	Location *		
Category	Supplemental			GPS Latitude/Longitude		
				Start	End	
Item	DWR UCIP LMA Responsibility			37.216547 °	37.216547 °	
				-120.713000 °	-120.713000 °	
DWR ID	19870					
Comment Code						
Inspector Comment						
FS_ID:39473 DS_ID:19870 EP_NO: N/A Repair Type: Non-Urgent Crossing Status: Found UCIP Comments: 04/18/2014 Sediment buildup in pipe--recommend contacting owner to clear sediment. (DWR UCIP - O. Magana) FIELD_STRUCT_DESC: 24-inch corrugated metal gravity drainage pipe through the levee, 16.5 feet below the crown. Flap gate on the waterside (WS) end. Concrete headwall on each end. [Additional Reference(s): DWR Levee Log, 2002. USACE San Joaquin O&M Manual 601.1, 1967, (HLM 8.21)]. FS Date: 4/18/2014

Concrete headwall and flap gate visible on waterward side.

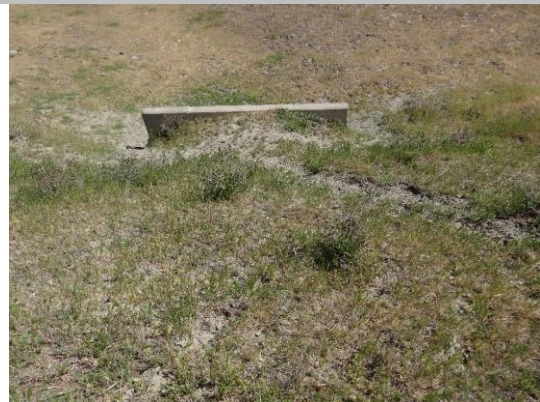
Photo 1 of 3 : UCIP\_SP\_2019\_39474\_61685.jpg

Comment Code						
Inspector Comment						
FS_ID:39474 DS_ID:19871 EP_NO: N/A Repair Type: Non-Urgent Crossing Status: Found UCIP Comments: 04/18/2014 Need to contact owner. Sediment buildup in pipe visible on landward side--recommend clearing. Good candidate for pressure test or video inspection due to signs of heavy corrosion. If no leaks after tests this crossing would be a good candidate for rehabilitation. (DWR UCIP - O. Magana) FIELD_STRUCT_DESC: 24-inch corrugated metal gravity drainage pipe through the levee, 9.2 feet below the crown. Flap gate on the waterside (WS) end. Concrete headwall on each end. [Additional Reference(s): DWR Levee Log, 2002. USACE San Joaquin O&M Manual 601.1, 1967, (HLM 8.51)]. FS Date: 4/18/2014

View of waterward side.

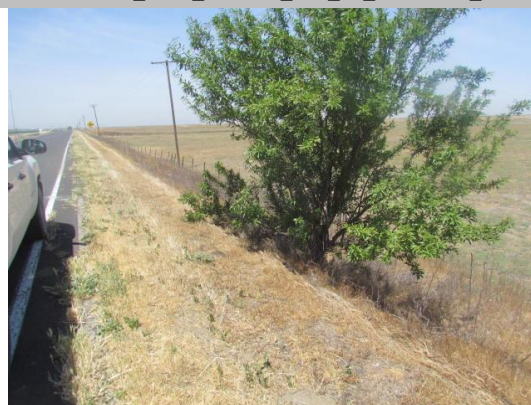
Photo 1 of 1 : SP\_2019\_NA0010\_124\_14\_20190307\_00014.jpg

LM Start	11.49	Rating **	M	Issue No.	14
LM End	11.49	Issue Type +	Ma	Location *	WS
Category	Earthen Levee			GPS Latitude/Longitude	
				Start	End
Item	Trim / Thin Trees			37.186189 °	37.186189 °
				-120.668476 °	-120.668476 °
DWR ID	DWR_NA0010_06_s_2015_14				
Comment Code					
T1 : Trim trees to at least five feet above ground level.					
Inspector Comment					
Almond tree located along Sandy Mush Road on waterside slope.

Looking west at tree on waterward slope.

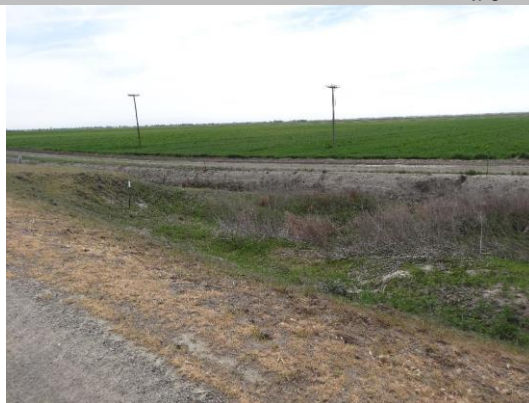
Photo 2 of 3 : UCIP\_SP\_2019\_39476\_66487.jpg

LM Start	11.74	Rating **	M	Issue No.	1248 (cont)	
LM End	11.74	Issue Type +	Ma	Location *		
Category	Supplemental			GPS Latitude/Longitude		
				Start	End	
Item	DWR UCIP LMA Responsibility			37.185513 °	37.185513 °	
				-120.664561 °	-120.664561 °	
DWR ID	19876					
Comment Code						
Inspector Comment						
FS_ID:39476						
DS_ID:19876						
EP_NO: N/A						
Repair Type: Non-Urgent						
Crossing Status: Found						
UCIP Comments: 04/17/2014 Clear debris from waterward and landward toes. (DWR UCIP - O. Magana)						
FIELD_STRUCT_DESC: 36-inch corrugated metal gravity drainage pipe through the levee, 17 feet below the crown. Slide gate in a pipe riser on the waterside (WS) slope. [Additional Reference(s): DWR Levee Log, 2002. USACE San Joaquin O&M Manual 601.1, 1967, (HLM 11.82)].						
FS Date: 4/17/2014

View of landward side.
