**Flood Control Project Maintenance  
Levee Inspections**

## Maintenance Issue Types Only, Levee Inspection Report By Mile - Spring 2019

### Lower San Joaquin Levee District

Waterway	Bank	Unit Miles	Inspection Start/End	Inspector
Unit No. 01 San Joaquin River	Right	22.52	03/26/2019 03/26/2019	Corey Fujitani

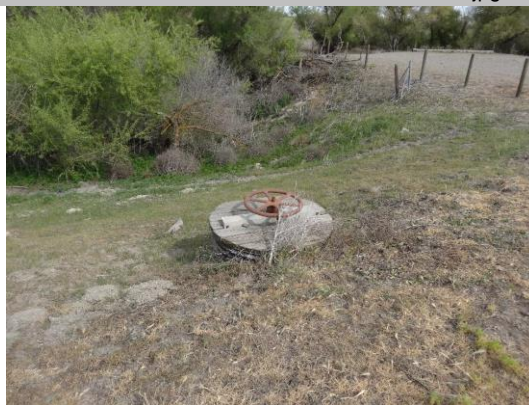
Photo 3 of 3 : UCIP\_SP\_2019\_39476\_66486.jpg

Slide gate inside CMP riser located on waterward slope.

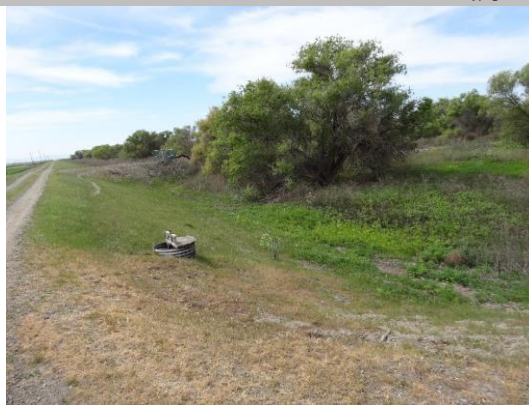
Photo 2 of 3 : UCIP\_SP\_2019\_39477\_66494.jpg

View of waterward slope.

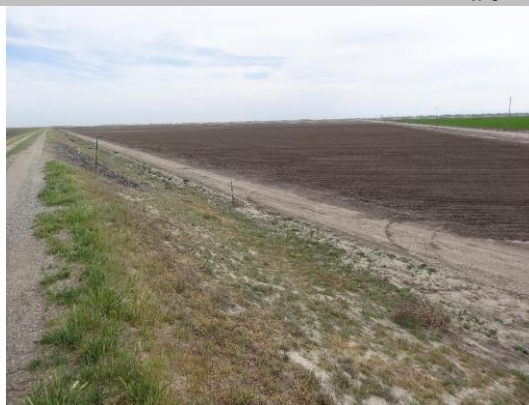
Photo 3 of 3 : UCIP\_SP\_2019\_39478\_66498.jpg

View of landward slope.

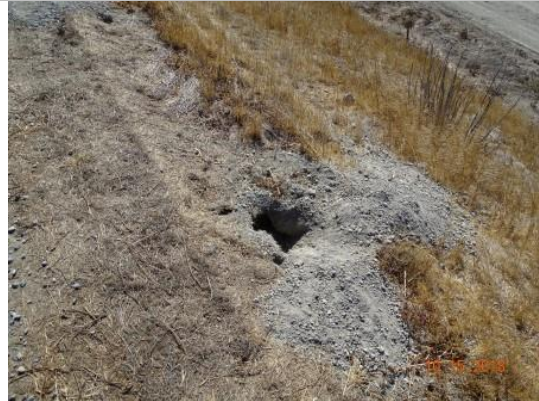
Photo 1 of 1 : SP\_2019\_NA0010\_124\_101\_20190307\_00043.jpg

LM Start	14.63	Rating **	M	Issue No.	101
LM End	14.64	Issue Type +	Ma	Location *	LS
Category	Earthen Levee			GPS Latitude/Longitude	
				Start	End
Item	Animal Control			37.164871 °	37.164824 °
				-120.633222 °	-120.633167 °
DWR ID	DWR_NA0010_06_f _ 2018_101				
Comment Code					
A3 : No rodents visible, but rodent burrows visible; need to backfill and compact or grout burrows.					
Inspector Comment					
Burrows are located along landside shoulder.

View of rodent hole on landside shoulder. (Fall 2018)

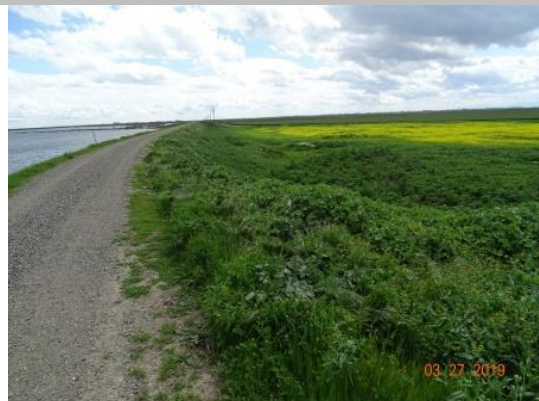
Photo 1 of 1 : SP\_2019\_NA0010\_124\_104\_20190418\_00195.jpg

LM Start	15.50	Rating **	U	Issue No.	104
LM End	15.74	Issue Type +	Ma	Location *	LS
Category	Earthen Levee			GPS Latitude/Longitude	
				Start	End
Item	Vegetation			37.158632 °	37.156358 °
				-120.619631 °	-120.616420 °
DWR ID	DWR_NA0010_06_f_2018_104				
Comment Code					
V1 : Control annual grass and weeds on the levee slopes and easements.					
Inspector Comment

View of vegetation on landside slope looking upstream. (Spring 2019)

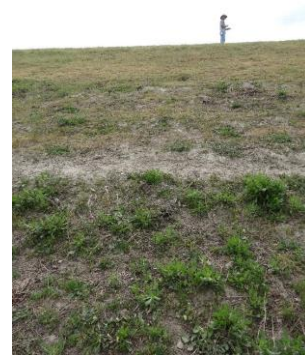
Comment Code						
Inspector Comment						
FS_ID:36663						
DS_ID:19885						
EP_NO: N/A						
Repair Type: Non-Urgent						
Crossing Status: Found						
UCIP Comments: 04/17/2014 Need to contact owner to determine status of crossing. Waterward side is buried and not accessible. Landward side headwall is blocked by dense vegetation. Recommend confirming status of flap gate on waterward side and removing dense vegetation form landward side. (DWR UCIP - O. Magana)						
FIELD_STRUCT_DESC: 36-inch corrugated metal gravity drainage pipe through the levee, 16.6 feet below the crown. Flap gate on the waterside (WS) end. [Additional Reference(s): DWR Levee Log, 2002. USACE San Joaquin O&M Manual 601.1, 1967, (HLM 15.91)].						
FS Date: 4/17/2014

View of waterward side, Photo 1 of 3.

View of waterward side, photo 2 of 3.

View of waterward side, photo 3 of 3.

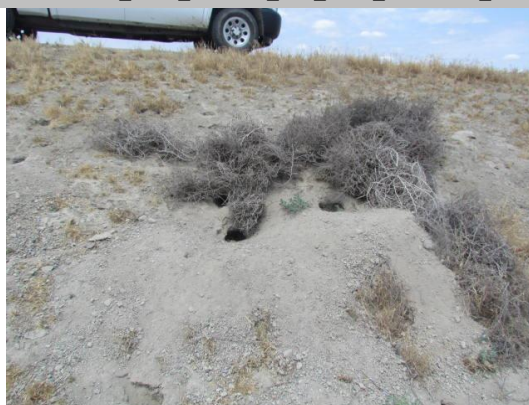
Photo 5 of 5 : SP\_2019\_NA0010\_124\_1211\_20190307\_00057.jpg

Looking west at several rodent holes on waterward slope. Spring 2015

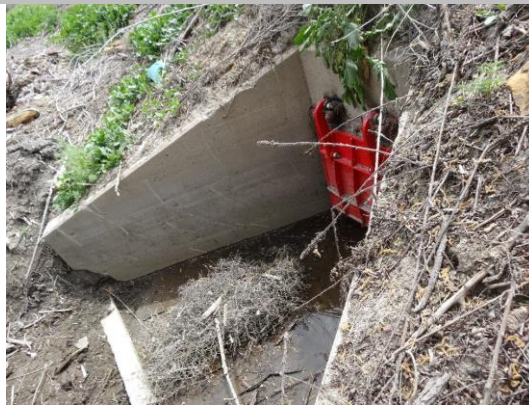
Comment Code						
Inspector Comment						
FS_ID:36689						
DS_ID:19891						
EP_NO: N/A						
Repair Type: Non-Urgent						
Crossing Status: Found						
UCIP Comments: 04/17/2014 Dense vegetation limits the inspector's visibility to identify signs of pipe failure (leaks) along the slopes. Recommend removing vegetation along pipe alignment to conduct proper inspection of structure. (DWR UCIP - O. Magana)						
FIELD_STRUCT_DESC: 30-inch by 30-inch reinforced concrete box gravity drainage culvert through the levee, 14 feet below the crown. Flap gate on the waterside (WS) end. [Additional Reference(s): DWR Levee Log, 2002. USACE San Joaquin O&M Manual 601.1, 1967, (HLM 19.85)].						
FS Date: 4/17/2014

Overview of levee crown looking downstream.

View of levee crown at crossing.

View of "U" concrete headwall located on waterward side.

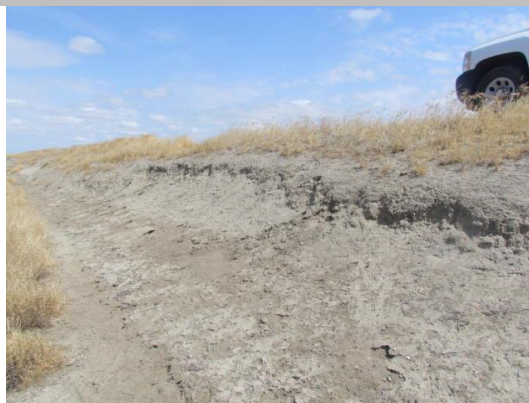
Photo 2 of 2 : SP\_2019\_NA0010\_124\_1209\_20190307\_00052.jpg

LM Start	20.79	Rating **	M	Issue No.	1209
LM End	21.10	Issue Type +	Ma	Location *	LS
Category	Earthen Levee			GPS Latitude/Longitude	
				Start	End
Item	Erosion / Bank Caving			37.113107 °	37.109735 °
				-120.563782 °	-120.560079 °
DWR ID	DWR_NA0010_06_s_2015_1209				
Comment Code					
E1 : Note and monitor erosion site.					
Inspector Comment					
Erosion on landside slope greater than 3 inches. Erosion caused by livestock.

Looking northeast at livestock erosion on landward slope.

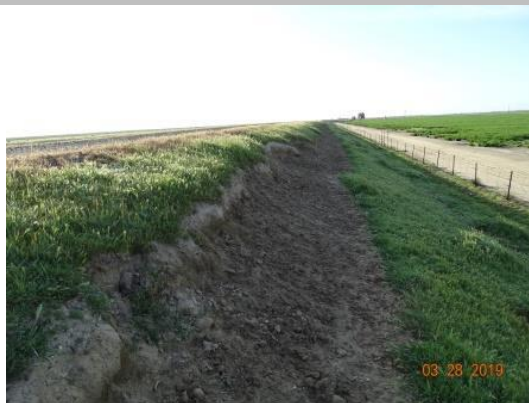
Photo 1 of 3 : SP\_2019\_NA0010\_124\_107\_20190418\_00197.jpg

LM Start	21.71	Rating **	M	Issue No.	107
LM End	21.78	Issue Type +	Ma	Location *	LS
Category	Earthen Levee			GPS Latitude/Longitude	
				Start	End
Item	Erosion / Bank Caving			37.102844 °	37.102002 °
				-120.553160 °	-120.552314 °
DWR ID	DWR_NA0010_06_f_2018_107				
Comment Code					
E1 : Note and monitor erosion site.					
Inspector Comment					
Erosion into levee prism due to livestock activities.

View of erosion in landside levee prism. (Spring 2019)

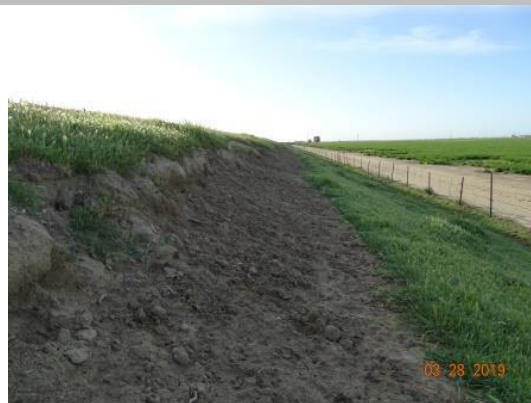
Photo 2 of 3 : SP\_2019\_NA0010\_124\_107\_20190418\_00196.jpg

View of erosion looking upstream. (Spring 2019)

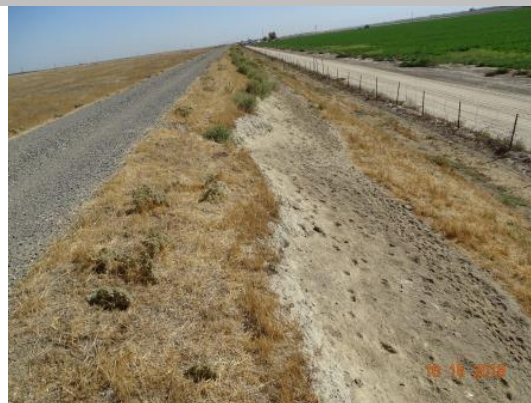
Photo 3 of 3 : SP\_2019\_NA0010\_124\_107\_20190307\_00046.jpg

Erosion into levee prism from livestock. (Fall 2018)

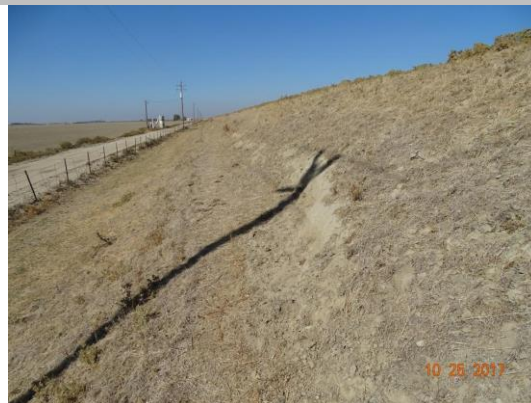
Photo 1 of 1 : SP\_2019\_NA0010\_124\_86\_20190307\_00034.jpg

LM Start	22.41	Rating **	M	Issue No.	86
LM End	22.46	Issue Type +	Ma	Location *	LS
Category	Earthen Levee			GPS Latitude/Longitude	
				Start	End
Item	Slope Stability			37.094969 °	37.094479 °
				-120.544964 °	-120.544435 °
DWR ID	DWR_NA0010_06_f_2017_86				
Comment Code					
S2 : Repair the levee slope damaged by foot traffic and prevent access where possible.					
Inspector Comment					
Erosion greater than 3 inches on landside slope caused by livestock.

Looking northwest at the landside slope.

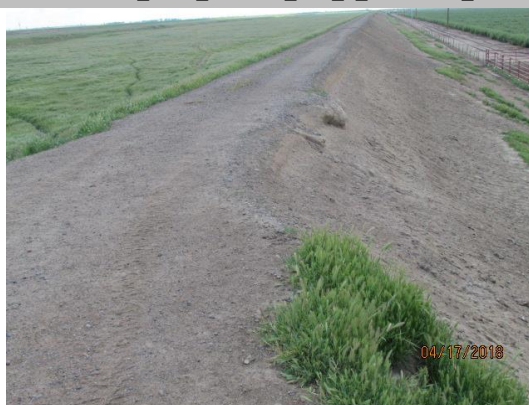
Photo 1 of 4 : SP\_2019\_NA0010\_124\_5\_20190307\_00008.jpg

LM Start	24.51	Rating **	M	Issue No.	5
LM End	25.01	Issue Type +	Ma	Location *	LS
Category	Earthen Levee			GPS Latitude/Longitude	
				Start	End
Item	Slope Stability			37.072048 °	37.066501 °
				-120.520180 °	-120.514193 °
DWR ID	DWR_NA0010_06_s_2012_5				
Comment Code					
S2 : Repair the levee slope damaged by foot traffic and prevent access where possible.					
Inspector Comment					
Landside erosion caused by livestock extends into landward shoulder. Erosion beginning to eat into the crown of the levee.

Looking north at livestock erosion into landward shoulder. (Spring 2018)

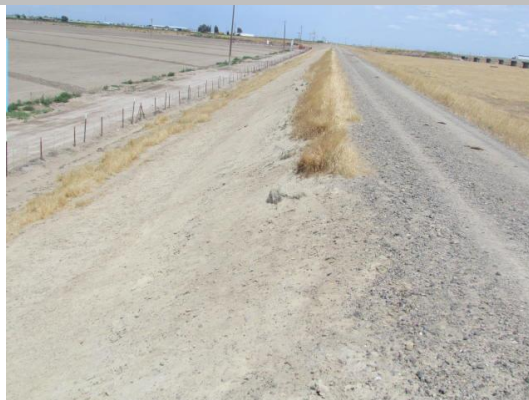
Photo 2 of 4 : SP\_2019\_NA0010\_124\_5\_20190307\_00009.jpg

Looking north at livestock erosion on landward slope. (Spring 2015)

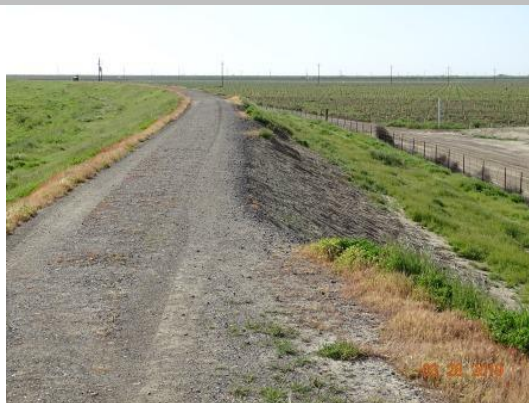
Photo 1 of 3 : SP\_2019\_NA0010\_124\_3\_20190418\_00199.jpg

LM Start	27.43	Rating **	M	Issue No.	3
LM End	27.97	Issue Type +	Ma	Location *	LS
Category	Earthen Levee			GPS Latitude/Longitude	
				Start	End
Item	Slope Stability			37.036955 °	37.032887 °
				-120.484395 °	-120.481225 °
DWR ID	DWR_NA0010_06_s_2012_3				
Comment Code					
S2 : Repair the levee slope damaged by foot traffic and prevent access where possible.					
Inspector Comment					
Landside erosion caused by livestock. Erosion greater than 3" in depth on landside slope. Levee crown has narrowed within this reach.

Looking south along landside slope. (Spring 2019)

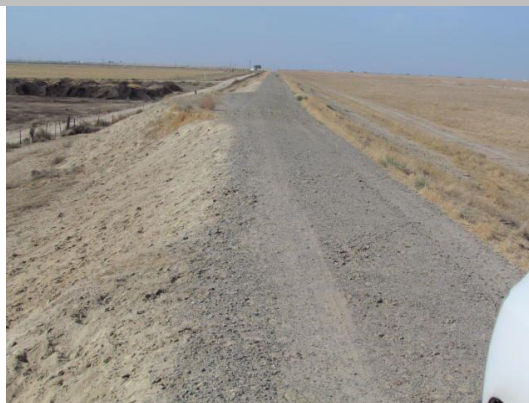
Photo 2 of 3 : SP\_2019\_NA0010\_124\_3\_20190307\_00004.jpg

Looking north at livestock erosion on landward slope. Fall 2015

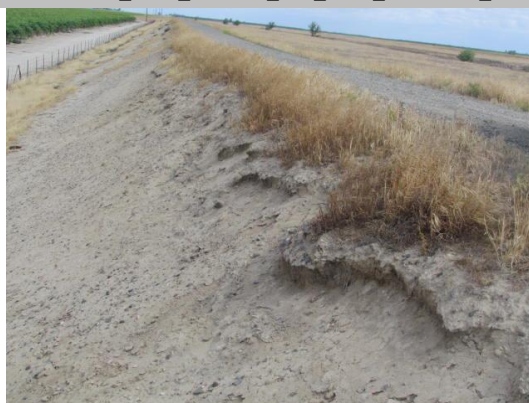
Photo 1 of 2 : SP\_2019\_NA0010\_124\_1207\_20190307\_00048.jpg

LM Start	30.81	Rating **	M	Issue No.	1207
LM End	31.06	Issue Type +	Ma	Location *	LS
Category	Earthen Levee			GPS Latitude/Longitude	
				Start	End
Item	Erosion / Bank Caving			37.021615 °	37.018428 °
				-120.437587 °	-120.435378 °
DWR ID	DWR_NA0010_06_s_2015_1207				
Comment Code					
E1 : Note and monitor erosion site.					
Inspector Comment					
Landside erosion greater than 1" in depth and greater than 3" in length. Erosion is caused by livestock traffic.

Looking northeast at livestock erosion on landward slope.

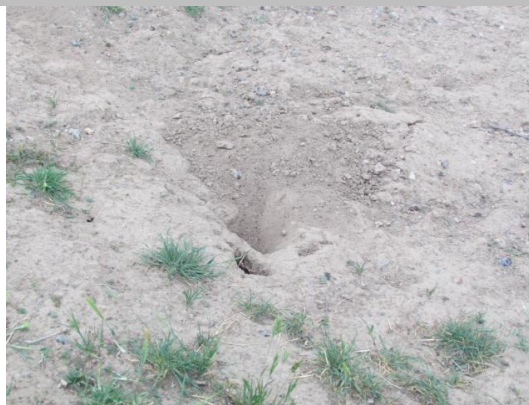
Photo 2 of 2 : SP\_2019\_NA0010\_124\_2\_20190307\_00002.jpg

Looking at typical rodent hole on landside slope.

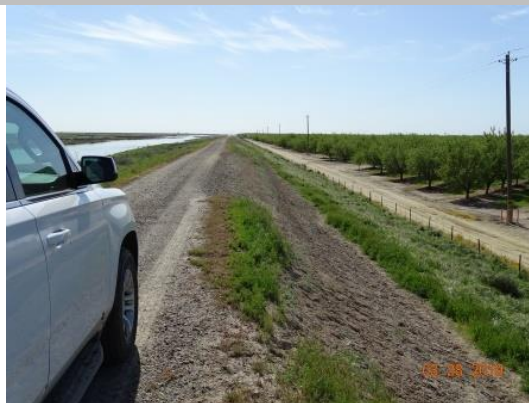
Photo 1 of 1 : SP\_2019\_NA0010\_124\_129\_20190418\_00207.jpg

LM Start	32.62	Rating **	M	Issue No.	129
LM End	32.87	Issue Type +	Ma	Location *	LS
Category	Earthen Levee			GPS Latitude/Longitude	
				Start	End
Item	Slope Stability			37.000645 °	36.997930 °
				-120.418415 °	-120.415406 °
DWR ID	DWR_NA0010_06_s_2019_129				
Comment Code					
S2 : Repair the levee slope damaged by foot traffic and prevent access where possible.					
Inspector Comment					
Slope damage from livestock. Damage is beginning to erode into levee crown.

Erosion from animal activity along the landside slope. (Spring 2019)

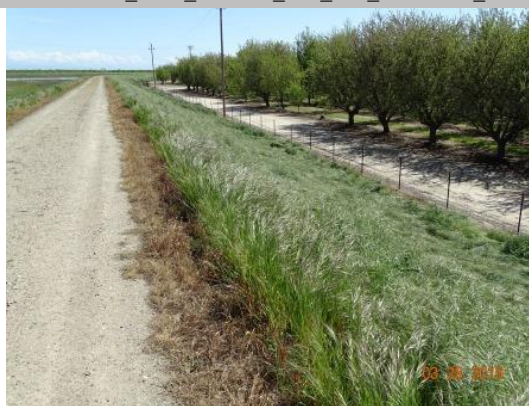
Photo 1 of 1 : SP\_2019\_NA0010\_124\_131\_20190418\_00208.jpg

LM Start	35.83	Rating **	U	Issue No.	131
LM End	36.46	Issue Type +	Ma	Location *	LS
Category	Earthen Levee			GPS Latitude/Longitude	
				Start	End
Item	Vegetation			36.974391 °	36.974226 °
				-120.374734 °	-120.363405 °
DWR ID	DWR_NA0010_06_s_2019_131				
Comment Code					
V1 : Control annual grass and weeds on the levee slopes and easements.					
Inspector Comment

View of vegetation along landside slope. (Spring 2019)

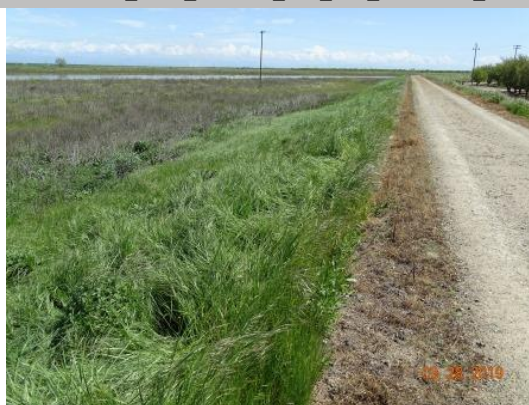
Photo 1 of 1 : SP\_2019\_NA0010\_124\_132\_20190418\_00209.jpg

LM Start	35.83	Rating **	U	Issue No.	132
LM End	36.46	Issue Type +	Ma	Location *	WS
Category	Earthen Levee			GPS Latitude/Longitude	
				Start	End
Item	Vegetation			36.974391 °	36.974225 °
				-120.374734 °	-120.363404 °
DWR ID	DWR_NA0010_06_s_2019_132				
Comment Code					
V1 : Control annual grass and weeds on the levee slopes and easements.					
Inspector Comment

Vegetation along waterside slope looking upstream. (Spring 2019)

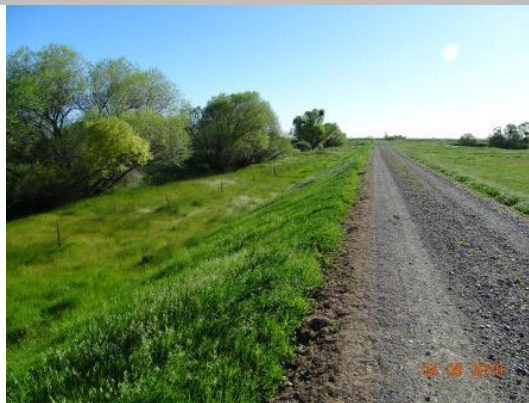
Photo 1 of 1 : SP\_2019\_NA0010\_125\_22\_20190423\_00047.jpg

LM Start	0.01	Rating **	M	Issue No.	22
LM End	1.17	Issue Type +	Ma	Location *	WS
Category	Earthen Levee			GPS Latitude/Longitude	
				Start	End
Item	Vegetation			37.255614 °	37.264431 °
				-120.772242 °	-120.756672 °
DWR ID	DWR_NA0010_07_s_2019_22				
Comment Code					
V1 : Control annual grass and weeds on the levee slopes and easements.					
Inspector Comment

View of waterside slope looking downstream. (Spring 2019)

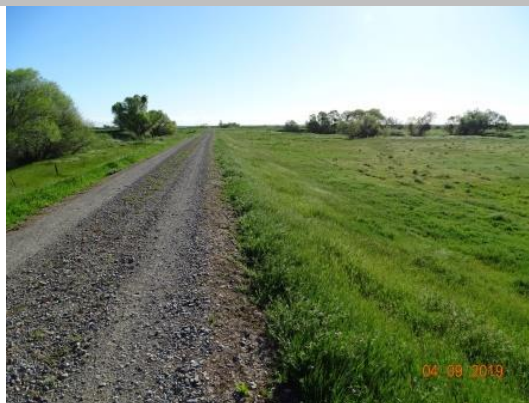
Photo 1 of 1 : SP\_2019\_NA0010\_125\_17\_20190423\_00048.jpg

LM Start	0.01	Rating **	M	Issue No.	17
LM End	1.42	Issue Type +	Ma	Location *	LS
Category	Earthen Levee			GPS Latitude/Longitude	
				Start	End
Item	Vegetation			37.255615 °	37.264277 °
				-120.772242 °	-120.752093 °
DWR ID	DWR_NA0010_07_s_2019_17				
Comment Code					
V1 : Control annual grass and weeds on the levee slopes and easements.					
Inspector Comment

View of landside slope looking downstream. (Spring 2019)

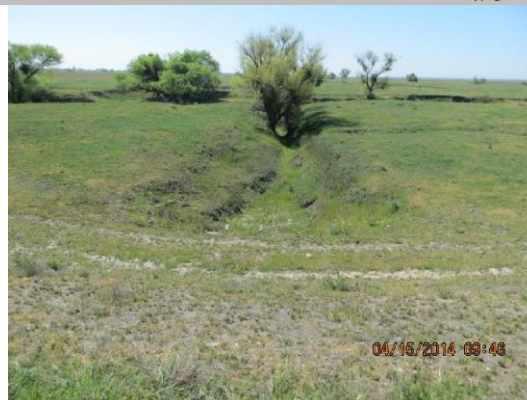
Photo 1 of 3 : UCIP\_SP\_2019\_49966\_60954.jpg

Comment Code					
Inspector Comment					
FS_ID:49966					
DS_ID:19892					
EP_NO: N/A					
Repair Type: Non-Urgent					
Crossing Status: Found					
UCIP Comments: 07/20/2016 Inlet blocked off by wooden board. Dense vegetation limits the inspector's visibility to identify signs of pipe failure (leaks) along WS and LS. Crossing downgraded from Urgent to Non-Urgent. (DWR UCIP - omagana)04/15/2014 Flapgate partially blocked by soil buildup at WS toe. (DWR UCIP - W. Wylie)					
FIELD_STRUCT_DESC: 24-inch corrugated metal gravity drainage pipe through the levee, 10.8 feet below the crown. Flap gate on the waterside (WS) end. Concrete headwall on the landside (LS) end. Concrete U-shaped headwall on the WS end. [Additional Reference(s): DWR Levee Log, 2002. USACE San Joaquin O&M Manual 601.1, 1967, (HLM 0.07)].					
FS Date: 7/20/2016

Pipe and headwall at WS toe.

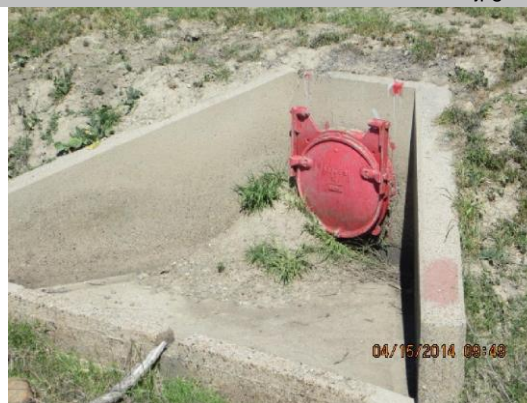
Photo 2 of 3 : UCIP\_SP\_2019\_49966\_60955.jpg

Pipe, headwall, and flapgate at WS toe. Soil buildup partially blocking flapgate.

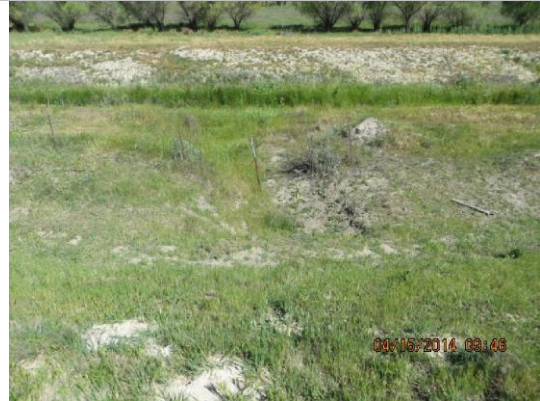
Photo 3 of 3 : UCIP\_SP\_2019\_49966\_60953.jpg

Comment Code						
Inspector Comment						
FS_ID:49966						
DS_ID:19892						
EP_NO: N/A						
Repair Type: Non-Urgent						
Crossing Status: Found						
UCIP Comments: 07/20/2016 Inlet blocked off by wooden board. Dense vegetation limits the inspector's visibility to identify signs of pipe failure (leaks) along WS and LS. Crossing downgraded from Urgent to Non-Urgent. (DWR UCIP - omagana)04/15/2014 Flapgate partially blocked by soil buildup at WS toe. (DWR UCIP - W. Wylie)						
FIELD_STRUCT_DESC: 24-inch corrugated metal gravity drainage pipe through the levee, 10.8 feet below the crown. Flap gate on the waterside (WS) end. Concrete headwall on the landside (LS) end. Concrete U-shaped headwall on the WS end. [Additional Reference(s): DWR Levee Log, 2002. USACE San Joaquin O&M Manual 601.1, 1967, (HLM 0.07)].						
FS Date: 7/20/2016

Pipe and headwall at LS toe.

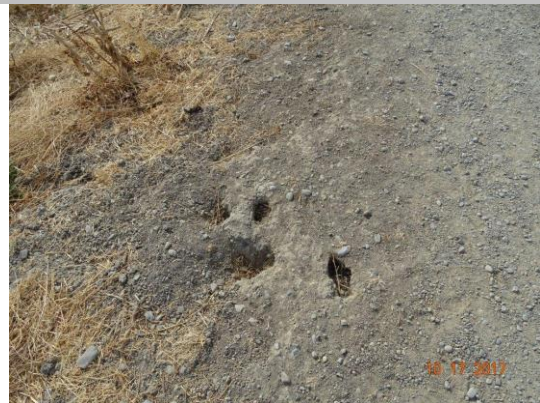
Photo 1 of 2 : SP\_2019\_NA0010\_125\_29\_20190307\_00012.jpg

LM Start	0.24	Rating **	M	Issue No.	29
LM End	0.50	Issue Type +	Ma	Location *	LS
Category	Earthen Levee			GPS Latitude/Longitude	
				Start	End
Item	Animal Control			37.256936 °	37.258722 °
				-120.768472 °	-120.764867 °
DWR ID	DWR_NA0010_07_s_2012_29				
Comment Code					
A3 : No rodents visible, but rodent burrows visible; need to backfill and compact or grout burrows.					
Inspector Comment					
Several rodent holes were noted on the landside and waterside slope and shoulder.

Looking north at landside slope.

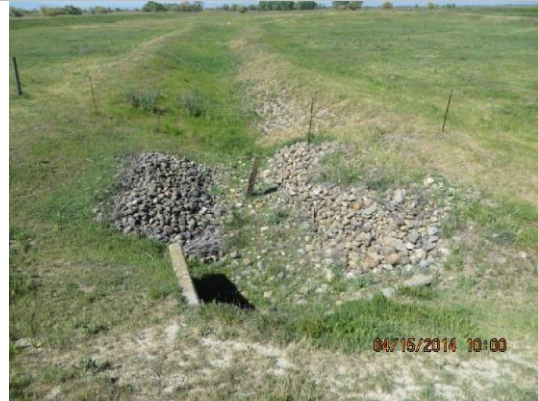
Photo 3 of 3 : UCIP\_SP\_2019\_33713\_60964.jpg

Comment Code						
Inspector Comment						
FS_ID:33713 DS_ID:19894 EP_NO: N/A Repair Type: Non-Urgent Crossing Status: Found UCIP Comments: 04/15/2014 Slide gate not operable, but left in closed position. Need to reinstall covers over slide gate standpipe. (DWR UCIP - W. Wylie) FIELD_STRUCT_DESC: 36-inch corrugated metal gravity drainage pipe through the levee, 9.7 feet below the crown. Slide gate in a 48-inch corrugated metal pipe (CMP) riser on the landside (LS) slope. Concrete U-shaped headwall on the LS end. Inlet channel cobble revetted. Dilapidated wooden pier on the waterside (WS). WS slope and outlet ditch cobble revetted. [Additional Reference(s): DWR Levee Log, 2002. USACE San Joaquin O&M Manual 601.1, 1967, (HLM 0.49)]. FS Date: 4/15/2014

Pipe and headwall on LS toe.

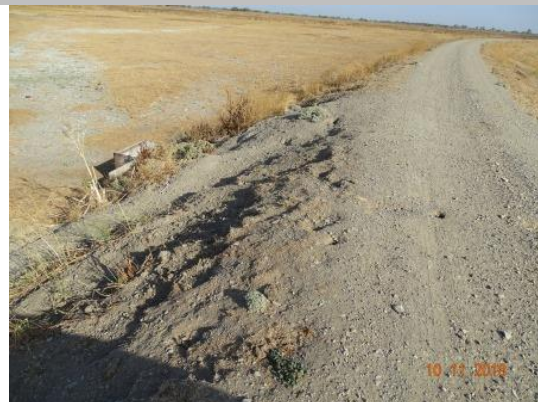
Photo 1 of 2 : SP\_2019\_NA0010\_125\_18\_20190307\_00008.jpg

LM Start	0.53	Rating **	M	Issue No.	18
LM End	0.53	Issue Type +	Ma	Location *	LS
Category	Earthen Levee			GPS Latitude/Longitude	
				Start	End
Item	Slope Stability			37.259097 °	37.259097 °
				-120.764846 °	-120.764846 °
DWR ID	DWR_NA0010_07_f_2018_18				
Comment Code					
S2 : Repair the levee slope damaged by foot traffic and prevent access where possible.					
Inspector Comment					
There is livestock damage to the landside slope.

View of damage from livestock looking upstream. (Fall 2018)

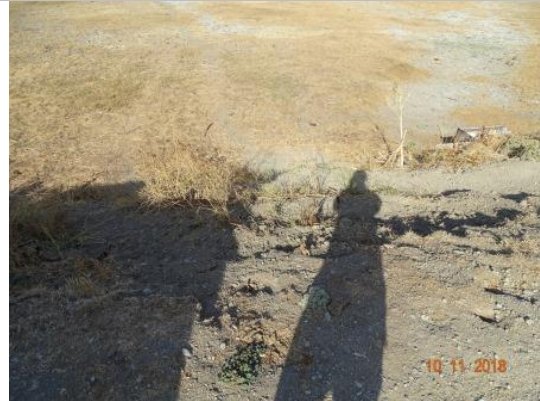
Photo 2 of 2 : SP\_2019\_NA0010\_125\_18\_20190307\_00009.jpg

LM Start	0.53	Rating **	M	Issue No.	18 (cont)	
LM End	0.53	Issue Type +	Ma	Location *	LS	
Category	Earthen Levee			GPS Latitude/Longitude		
				Start	End	
Item	Slope Stability			37.259097 °	37.259097 °	
				-120.764846 °	-120.764846 °	
DWR ID	DWR_NA0010_07_f_2018_18					
Comment Code						
S2 : Repair the levee slope damaged by foot traffic and prevent access where possible.						
Inspector Comment						
There is livestock damage to the landside slope.

View of damage looking down landside slope. (2018)

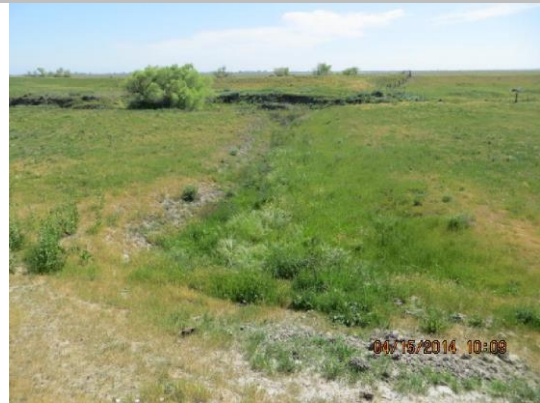
Photo 1 of 3 : UCIP\_SP\_2019\_33723\_60981.jpg

LM Start	0.53	Rating **	A/W	Issue No.	33
LM End	0.53	Issue Type +	Ma	Location *	
Category	Supplemental			GPS Latitude/Longitude	
				Start	End
Item	DWR UCIP LMA Responsibility			37.259163 °	37.259163 °
				-120.764860 °	-120.764860 °
DWR ID	19895				
Comment Code					
Inspector Comment					
FS_ID:33723					
DS_ID:19895					
EP_NO: N/A					
Repair Type: No Action Needed					
Crossing Status: Found					
UCIP Comments:					
FIELD_STRUCT_DESC: 24-inch corrugated metal gravity drainage pipe through the levee, 9 feet below the crown. Flap gate on the waterside (WS) end. Concrete headwall with a wooden weir at the inlet on the landside (LS) toe. Concrete U-shaped headwall on the WS toe.					
[Additional Reference(s): DWR Levee Log, 2002. USACE San Joaquin O&M Manual 601.1, 1967, (HLM 0.53)].					
FS Date: 4/15/2014

Headwall and flapgate on WS toe.

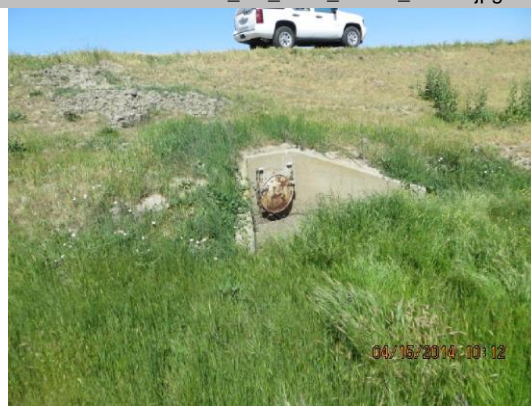
Photo 2 of 3 : UCIP\_SP\_2019\_33723\_60983.jpg

Flapgate on concrete headwall at WS toe.

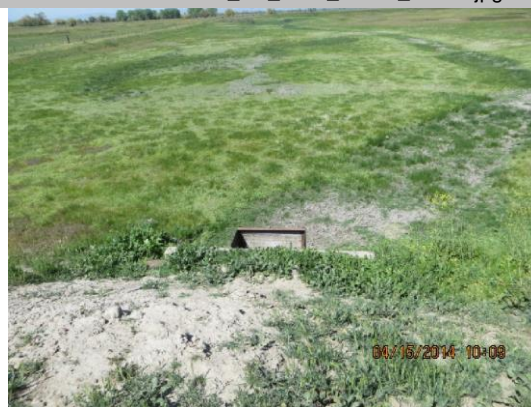
Photo 3 of 3 : UCIP\_SP\_2019\_33723\_60982.jpg

Headwall, pipe, and wier on LS toe.

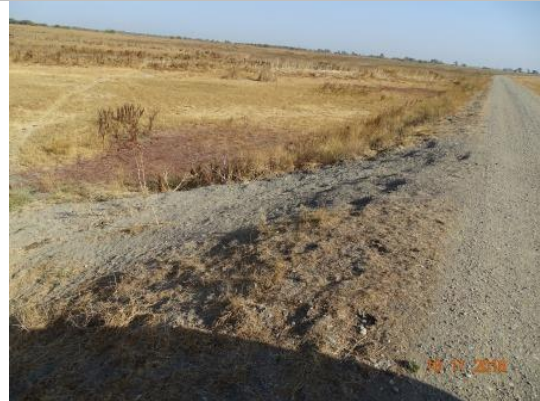
Photo 1 of 1 : SP\_2019\_NA0010\_125\_19\_20190307\_00010.jpg

LM Start	0.70	Rating **	M	Issue No.	19
LM End	0.70	Issue Type +	Ma	Location *	LS
Category	Earthen Levee			GPS Latitude/Longitude	
				Start	End
Item	Slope Stability			37.261337 °	37.261337 °
				-120.763303 °	-120.763303 °
DWR ID	DWR_NA0010_07_f_2018_19				
Comment Code					
S2 : Repair the levee slope damaged by foot traffic and prevent access where possible.					
Inspector Comment					
There is livestock damage to the landside slope.

Damage to landside slope from livestock. (Fall 2018)

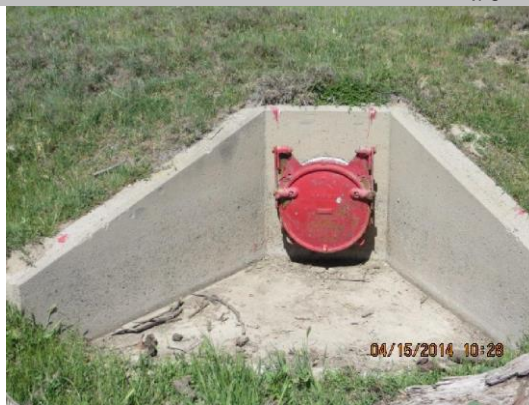
Photo 2 of 3 : UCIP\_SP\_2019\_33725\_60993.jpg

Concrete headwall and flapgate at WS toe.

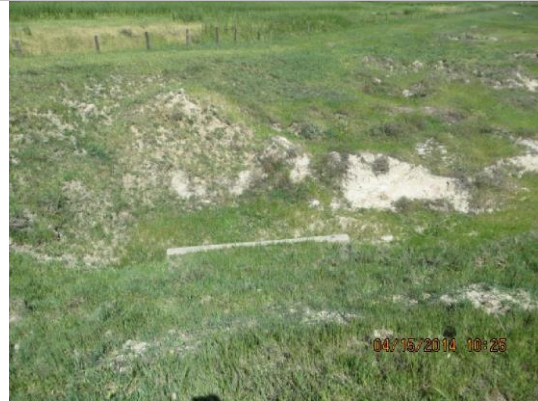
Photo 3 of 3 : UCIP\_SP\_2019\_33725\_60992.jpg

Concrete headwall and pipe on LS toe.

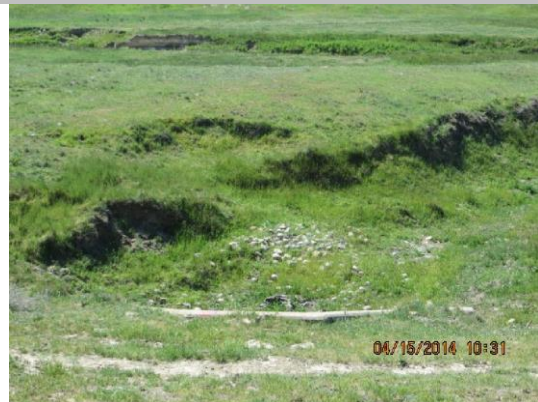
Photo 1 of 3 : UCIP\_SP\_2019\_33726\_60996.jpg

LM Start	1.17	Rating **	A/W	Issue No.	36
LM End	1.17	Issue Type +	Ma	Location *	
Category	Supplemental			GPS Latitude/Longitude	
				Start	End
Item	DWR UCIP LMA Responsibility			37.264421 °	37.264421 °
				-120.756683 °	-120.756683 °
DWR ID	19898				
Comment Code					
Inspector Comment					
FS_ID:33726					
DS_ID:19898					
EP_NO: N/A					
Repair Type: No Action Needed					
Crossing Status: Found					
UCIP Comments:					
FIELD_STRUCT_DESC: 48-inch corrugated metal gravity drainage pipe					
through the levee, 14.6 feet below the crown. Flap gate on the					
waterside (WS) end. Concrete U-shaped headwall on each end.					
[Additional Reference(s): DWR Levee Log, 2002. USACE San Joaquin					
O&M Manual 601.1, 1967, (HLM 1.17)].					
FS Date: 4/15/2014

Pipe, flapgate, and headwall on WS toe.

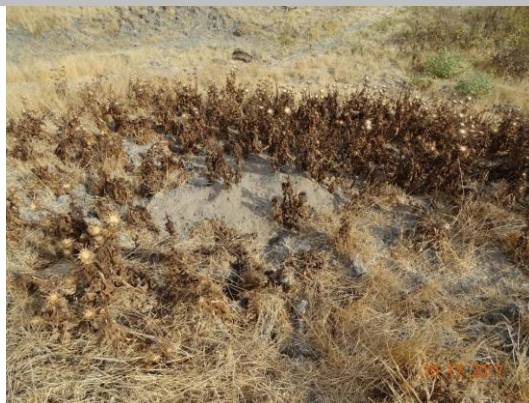
Photo 2 of 2 : SP\_2019\_NA0010\_125\_6\_20190307\_00004.jpg

Looking northwest at landside slope.

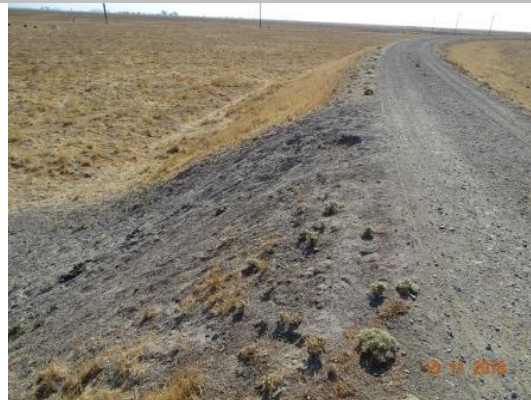
Photo 1 of 1 : SP\_2019\_NA0010\_125\_21\_20190307\_00011.jpg

LM Start	1.90	Rating **	M	Issue No.	21
LM End	1.90	Issue Type +	Ma	Location *	LS
Category	Earthen Levee			GPS Latitude/Longitude	
				Start	End
Item	Slope Stability			37.261379 °	37.261379 °
				-120.744228 °	-120.744228 °
DWR ID	DWR_NA0010_07_f_2018_21				
Comment Code					
S2 : Repair the levee slope damaged by foot traffic and prevent access where possible.					
Inspector Comment

Slope damage from livestock. (Fall 2018)

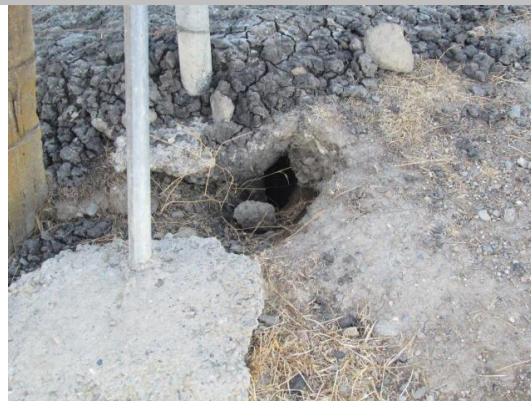
Photo 1 of 2 : SP\_2019\_NA0010\_125\_12\_20190307\_00005.jpg

LM Start	2.09	Rating **	M	Issue No.	12
LM End	2.09	Issue Type +	Ma	Location *	LS
Category	Earthen Levee			GPS Latitude/Longitude	
				Start	End
Item	Animal Control			37.259187 °	37.259187 °
				-120.742551 °	-120.742551 °
DWR ID	DWR_NA0010_07_f_2018_12				
Comment Code					
A3 : No rodents visible, but rodent burrows visible; need to backfill and compact or grout burrows.					
Inspector Comment					
Rodent activity is noted next to the fence post.

Looking east at rodent hole next to fence post on landward shoulder.

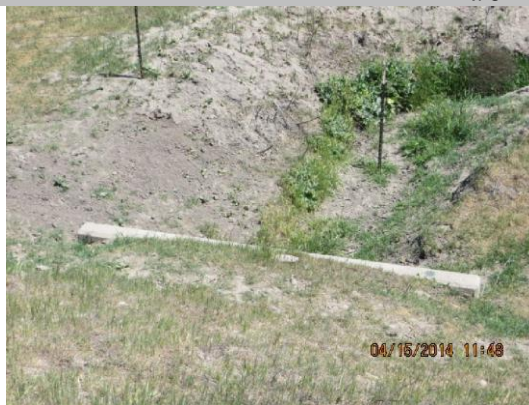
Photo 3 of 3 : UCIP\_SP\_2019\_33729\_61012.jpg

Concrete headwall and pipe at LS toe.

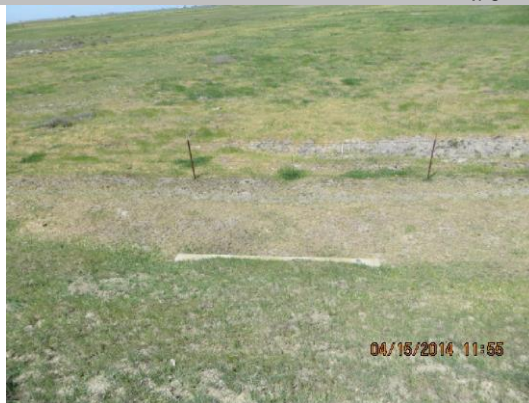
Photo 3 of 3 : UCIP\_SP\_2019\_39508\_61017.jpg

Headwall and pipe on LS toe.

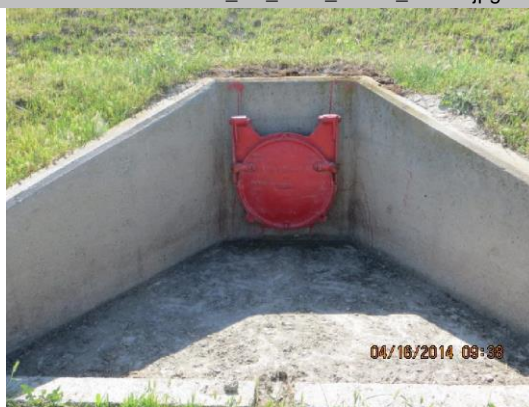
Photo 2 of 3 : UCIP\_SP\_2019\_33751\_61067.jpg

Headwall and flapgate on WS toe.

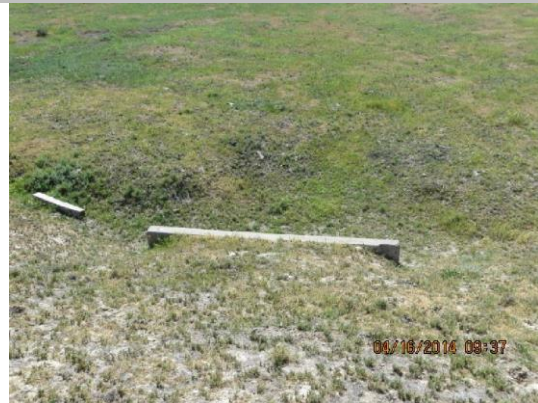
Photo 3 of 3 : UCIP\_SP\_2019\_33751\_61069.jpg

Concrete headwall on LS toe.

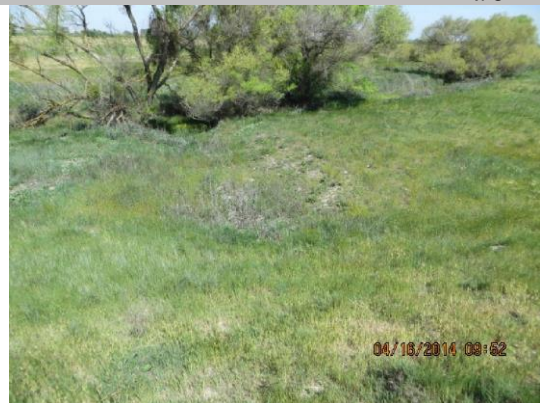
Photo 1 of 3 : UCIP\_SP\_2019\_33753\_61078.jpg

LM Start	0.72	Rating **	A/W	Issue No.	30
LM End	0.72	Issue Type +	Ma	Location *	
Category	Supplemental			GPS Latitude/Longitude	
				Start	End
Item	DWR UCIP LMA Responsibility			37.260306 °	37.260306 °
				-120.762127 °	-120.762127 °
DWR ID	19905				
Comment Code					
Inspector Comment					
FS_ID:33753					
DS_ID:19905					
EP_NO: N/A					
Repair Type: No Action Needed					
Crossing Status: Found					
UCIP Comments:					
FIELD_STRUCT_DESC: 24-inch corrugated metal gravity drainage pipe					
through the levee, 10 feet below the crown. Flap gate on the waterside					
(WS) end. Concrete headwall on each end. [Additional Reference(s):					
DWR Levee Log, 2002. USACE San Joaquin O&M Manual 601.1, 1967,					
(HLM 0.72)].					
FS Date: 4/16/2014

Headwall and flapgate at WS toe.

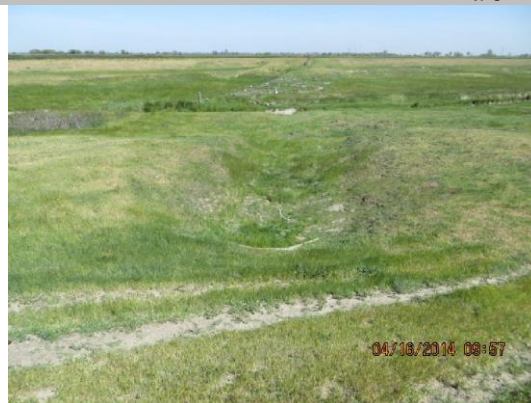
Photo 1 of 3 : UCIP\_SP\_2019\_39887\_61084.jpg

LM Start	0.90	Rating **	M	Issue No.	31
LM End	0.90	Issue Type +	Ma	Location *	
Category	Supplemental			GPS Latitude/Longitude	
				Start	End
Item	DWR UCIP LMA Responsibility			37.262384 °	37.262384 °
				-120.760528 °	-120.760528 °
DWR ID	19832				
Comment Code					
Inspector Comment					
FS_ID:39887 DS_ID:19832 EP_NO: N/A Repair Type: Non-Urgent Crossing Status: Found UCIP Comments: 04/16/2014 Some sediment buildup at inlet on LS toe. (DWR UCIP - W. Wylie) FIELD_STRUCT_DESC: 24-inch corrugated metal gravity drainage pipe through the levee, 11.5 feet below the crown. Flap gate on the waterside (WS) end. Concrete headwall on each end. [Additional Reference(s): DWR Levee Log, 2002. USACE San Joaquin O&M Manual 601.1, 1967, (HLM 0.89)]. FS Date: 4/16/2014

Headwall, pipe, and flapgate on WS toe.

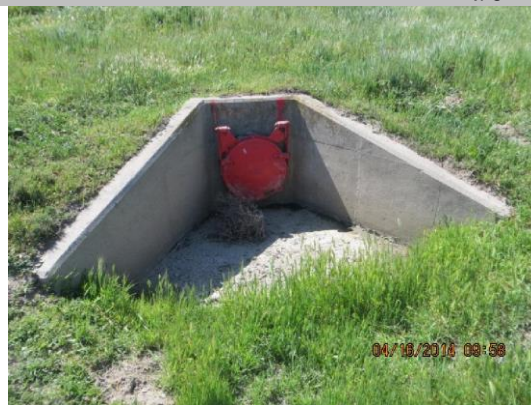
Photo 2 of 3 : UCIP\_SP\_2019\_39887\_61083.jpg

Headwall, pipe, and flapgate on WS toe.

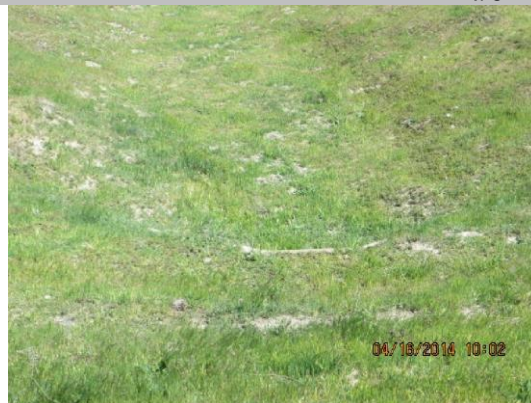
Photo 1 of 3 : UCIP\_SP\_2019\_39509\_61090.jpg

LM Start	1.21	Rating **	M	Issue No.	32
LM End	1.21	Issue Type +	Ma	Location *	
Category	Supplemental			GPS Latitude/Longitude	
				Start	End
Item	DWR UCIP LMA Responsibility			37.263188°	37.263188°
				-120.755399°	-120.755399°
DWR ID	19833				
Comment Code					
Inspector Comment					
FS_ID:39509 DS_ID:19833 EP_NO: N/A Repair Type: Non-Urgent Crossing Status: Found UCIP Comments: 04/16/2014 Debris blocking landward headwall--recommend clearing. (DWR UCIP - W. Wylie) FIELD_STRUCT_DESC: 24-inch corrugated metal gravity drainage pipe through the levee, 11.6 feet below the crown. Flap gate on the waterside (WS) end. Concrete headwall on each end. [Additional Reference(s): DWR Levee Log, 2002. USACE San Joaquin O&M Manual 601.1, 1967, (HLM 1.21)]. FS Date: 4/16/2014

Concrete headwall, pipe, and flapgate on WS toe.

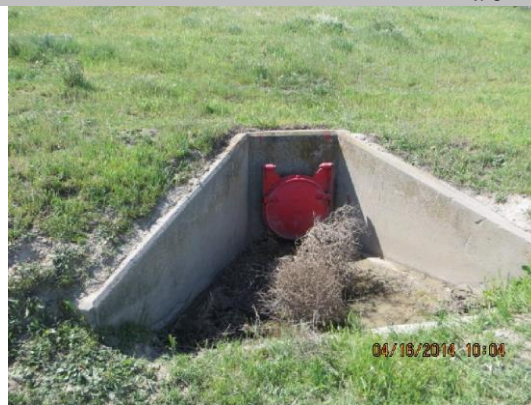
Photo 2 of 3 : UCIP\_SP\_2019\_39509\_61091.jpg

Concrete headwall, pipe, and flapgate on WS toe.

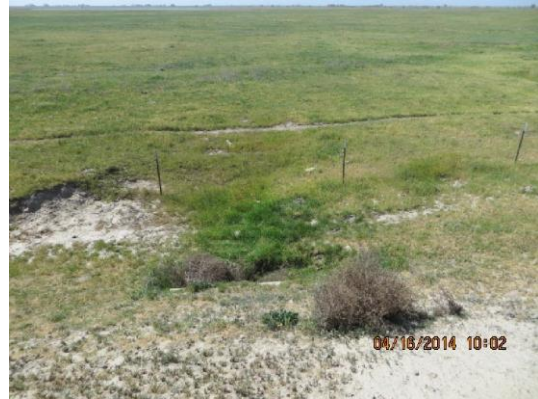
Photo 3 of 3 : UCIP\_SP\_2019\_39509\_61089.jpg

Pipe and headwall on LS toe.

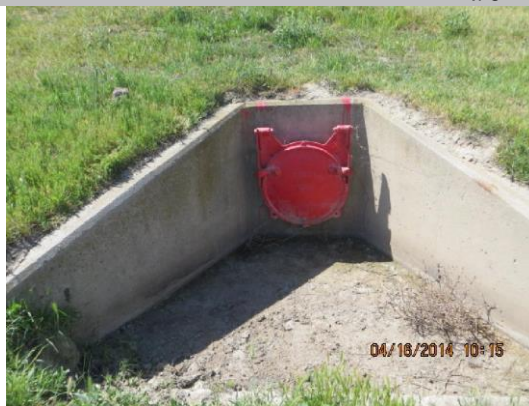
Photo 1 of 3 : UCIP\_SP\_2019\_39511\_61098.jpg

LM Start	2.05	Rating **	M	Issue No.	34
LM End	2.05	Issue Type +	Ma	Location *	
Category	Supplemental			GPS Latitude/Longitude	
				Start	End
Item	DWR UCIP LMA Responsibility			37.258220 °	37.258220 °
				-120.742868 °	-120.742868 °
DWR ID	19835				
Comment Code					
Inspector Comment					
FS_ID:39511 DS_ID:19835 EP_NO: N/A Repair Type: Non-Urgent Crossing Status: Found UCIP Comments: 04/16/2014 Non-functional landward inlet is buried in sediment. Need to contact owner to determine status. (DWR UCIP - W. Wylie) FIELD_STRUCT_DESC: 24-inch corrugated metal gravity drainage pipe through the levee, 12 feet below the crown. Flap gate on the waterside (WS) end. Concrete headwall on each end. [Additional Reference(s): DWR Levee Log, 2002. USACE San Joaquin O&M Manual 601.1, 1967, (HLM 2.05)]. FS Date: 4/16/2014

Pipe, headwall, and flapgate on Ws toe.

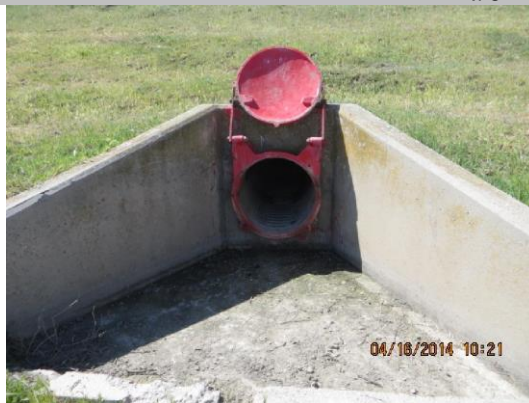
Photo 2 of 3 : UCIP\_SP\_2019\_39512\_61100.jpg

Pipe, headwall, and flapgate on WS toe.

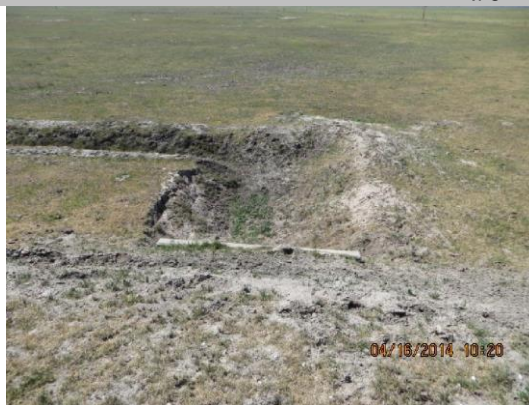
Photo 3 of 3 : UCIP\_SP\_2019\_39512\_61101.jpg

Pipe and headwall on LS toe.

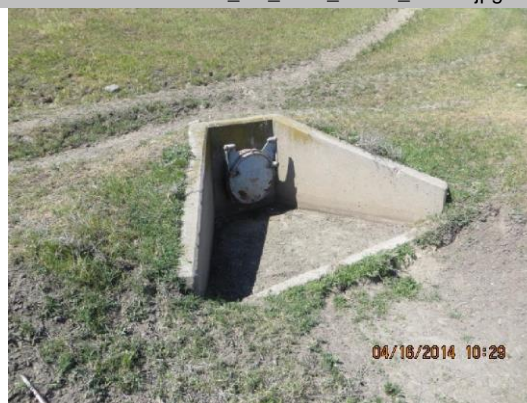
Photo 2 of 3 : UCIP\_SP\_2019\_33760\_61105.jpg

Pipe, headwall, and flapgate on Ws toe.

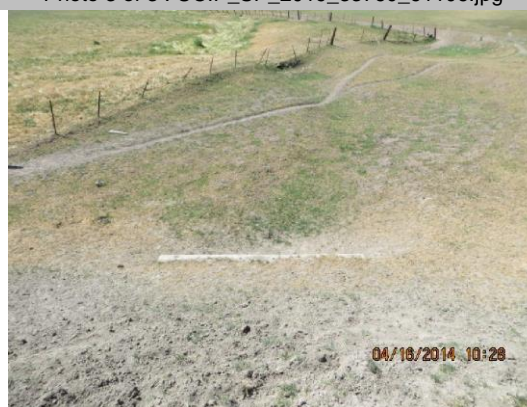
Photo 3 of 3 : UCIP\_SP\_2019\_33760\_61106.jpg

Pipe and headwall on LS toe.

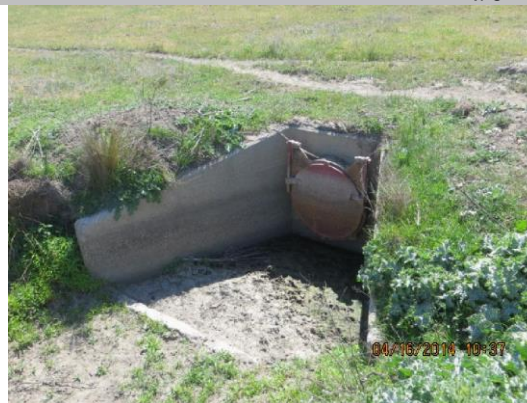
Photo 2 of 3 : UCIP\_SP\_2019\_49969\_61113.jpg

Pipe, headwall, and flapgate on WS toe.

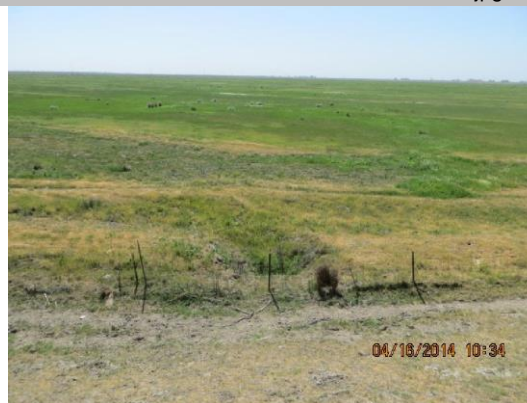
Photo 3 of 3 : UCIP\_SP\_2019\_49969\_61111.jpg

Pipe and headwall on LS toe.

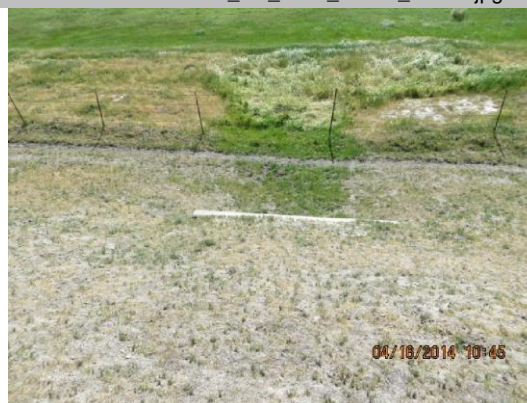
Photo 3 of 3 : UCIP\_SP\_2019\_33764\_61129.jpg

Pipe and headwall on LS toe.

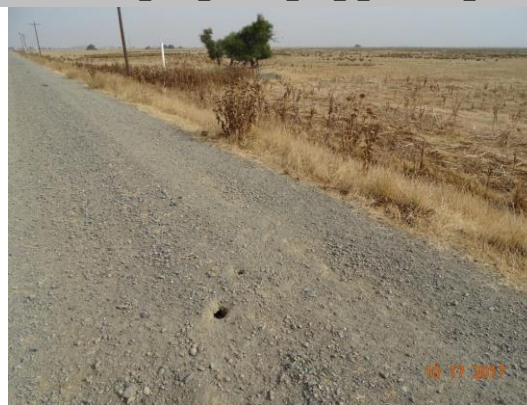
Photo 1 of 2 : SP\_2019\_NA0010\_126\_3\_20190307\_00002.jpg

LM Start	3.40	Rating **	M	Issue No.	3
LM End	3.54	Issue Type +	Ma	Location *	LS
Category	Earthen Levee			GPS Latitude/Longitude	
				Start	End
Item	Animal Control			37.253052 °	37.253600 °
				-120.722647 °	-120.720198 °
DWR ID	DWR_NA0010_08_s_2012_3				
Comment Code					
A3 : No rodents visible, but rodent burrows visible; need to backfill and compact or grout burrows.					
Inspector Comment					
Several rodent holes were noted on landside slope within this reach.

Looking east at the crown towards the landside.

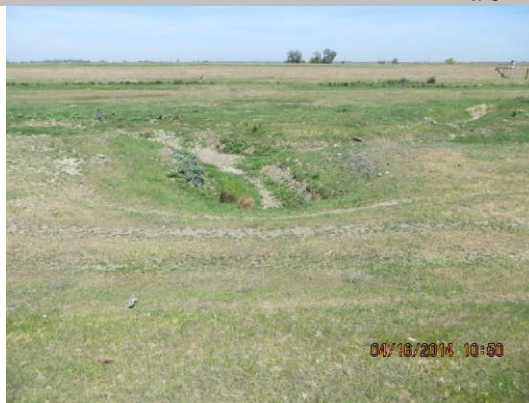
Photo 1 of 3 : UCIP\_SP\_2019\_39513\_61134.jpg

LM Start	3.43	Rating **	M	Issue No.	39
LM End	3.43	Issue Type +	Ma	Location *	
Category	Supplemental			GPS Latitude/Longitude	
				Start	End
Item	DWR UCIP LMA Responsibility			37.253151 °	37.253151 °
				-120.722182 °	-120.722182 °
DWR ID	19840				
Comment Code					
Inspector Comment					
FS_ID:39513 DS_ID:19840 EP_NO: N/A Repair Type: Non-Urgent Crossing Status: Found UCIP Comments: 04/16/2014 No access available on landward side. Need to confirm status of crossing. (DWR UCIP - W. Wylie) FIELD_STRUCT_DESC: 24-inch corrugated metal gravity drainage pipe through the levee, 13 feet below the crown. Flap gate on the waterside (WS) end. Concrete headwall on each end. [Additional Reference(s): DWR Levee Log, 2002. USACE San Joaquin O&M Manual 601.1, 1967, (HLM 3.43)]. FS Date: 4/16/2014

Pipe, headwall, and flapgate on WS toe.

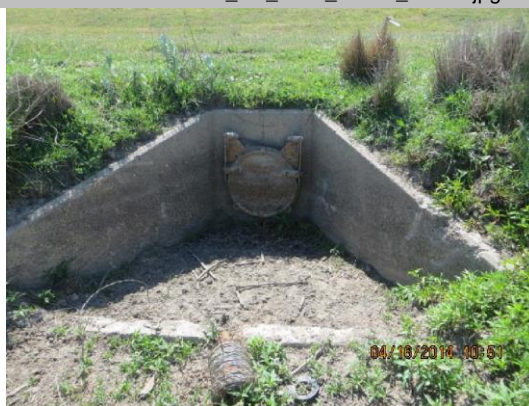
Photo 2 of 3 : UCIP\_SP\_2019\_39513\_61133.jpg

Pipe, headwall, and flapgate on WS toe.

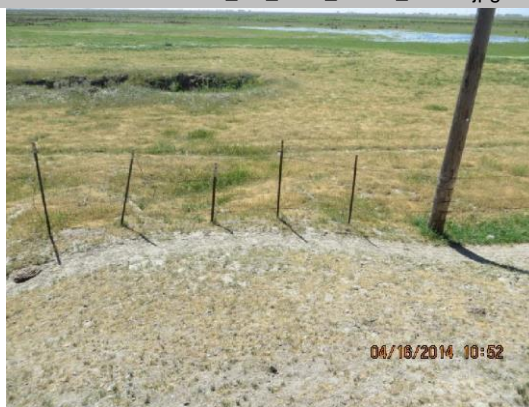
Photo 3 of 3 : UCIP\_SP\_2019\_39513\_61132.jpg

Pipe likely at drainage swale off LS toe.

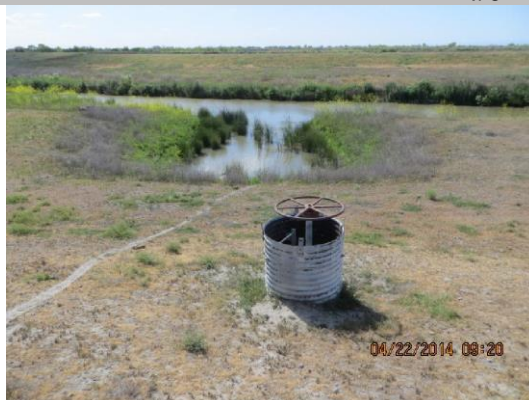
Photo 1 of 3 : UCIP\_SP\_2019\_39888\_62119.jpg

Comment Code						
Inspector Comment						
FS_ID:39888 DS_ID:19841 EP_NO: N/A Repair Type: Non-Urgent Crossing Status: Found UCIP Comments: 04/22/2014 Concrete headwalls on landward and waterward under water. Need photo to confirm condition of concrete headwalls, pipe, and gate on both toes. (DWR UCIP - W. Wylie) FIELD_STRUCT_DESC: 24-inch corrugated metal gravity drainage pipe through the levee, 18.7 feet below the crown. Slide gate in a 36-inch corrugated metal pipe (CMP) riser on the waterside (WS) slope. Concrete U-shaped headwall on each end. [Additional Reference(s): DWR Levee Log, 2002. USACE San Joaquin O&M Manual 601.1, 1967, (HLM 0.47)]. FS Date: 4/22/2014

Slide gate in CMP riser on WS slope with outlet visible in background.

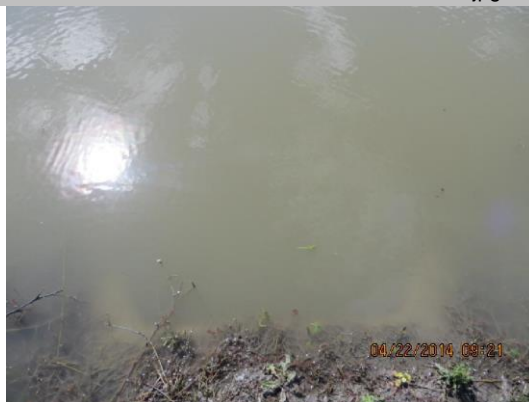
Photo 2 of 3 : UCIP\_SP\_2019\_39888\_62117.jpg

Concrete headwall visible under water on WS toe.

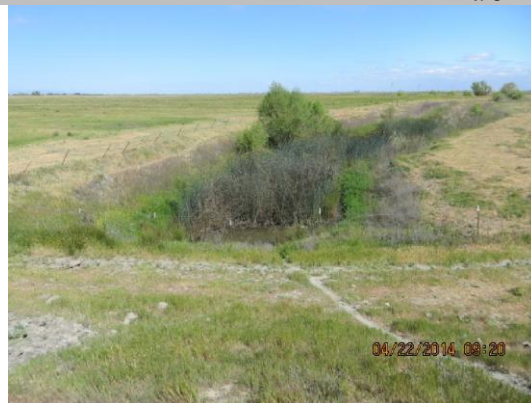
Photo 3 of 3 : UCIP\_SP\_2019\_39888\_62118.jpg

Comment Code						
Inspector Comment						
FS_ID:39888						
DS_ID:19841						
EP_NO: N/A						
Repair Type: Non-Urgent						
Crossing Status: Found						
UCIP Comments: 04/22/2014 Concrete headwalls on landward and waterward under water. Need photo to confirm condition of concrete headwalls, pipe, and gate on both toes. (DWR UCIP - W. Wylie)						
FIELD_STRUCT_DESC: 24-inch corrugated metal gravity drainage pipe through the levee, 18.7 feet below the crown. Slide gate in a 36-inch corrugated metal pipe (CMP) riser on the waterside (WS) slope.						
Concrete U-shaped headwall on each end. [Additional Reference(s): DWR Levee Log, 2002. USACE San Joaquin O&M Manual 601.1, 1967, (HLM 0.47)].						
FS Date: 4/22/2014

Concrete headwall visible at inlet on LS toe.

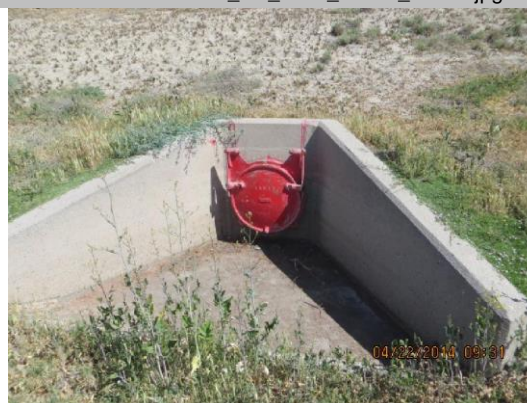
Photo 2 of 3 : UCIP\_SP\_2019\_39515\_62132.jpg

Headwall, flapgate, and pipe on WS toe.

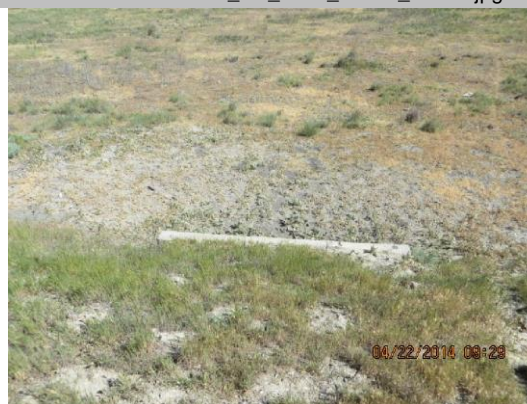
Photo 3 of 3 : UCIP\_SP\_2019\_39515\_62129.jpg

Comment Code						
Inspector Comment						
FS_ID:39515 DS_ID:19842 EP_NO: N/A Repair Type: Non-Urgent Crossing Status: Found UCIP Comments: 04/22/2014 Animal burrows in area on LS slope. Minor sediment buildup in pipe visible on landward side--recommend clearing. (DWR UCIP - W. Wylie) FIELD_STRUCT_DESC: 24-inch corrugated metal gravity drainage pipe through the levee, 8.7 feet below the crown. Flap gate on the waterside (WS) end. Concrete headwall on the landside (LS) end. Concrete U-shaped headwall on the WS end. [Additional Reference(s): DWR Levee Log, 2002. USACE San Joaquin O&M Manual 601.1, 1967, (HLM 0.70)]. FS Date: 4/22/2014

Headwall and pipe on LS toe.

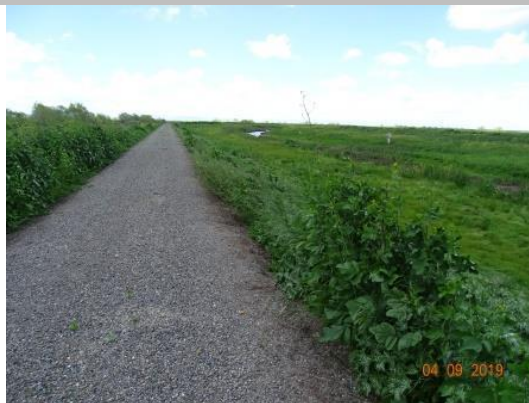
Photo 1 of 1 : SP\_2019\_NA0010\_128\_2\_20190426\_00005.jpg

LM Start	0.01	Rating **	U	Issue No.	2
LM End	0.79	Issue Type +	Ma	Location *	WS
Category	Earthen Levee			GPS Latitude/Longitude	
				Start	End
Item	Vegetation			37.217967 °	37.219354 °
				-120.711414 °	-120.698032 °
DWR ID	DWR_NA0010_10_s_2019_2				
Comment Code					
V1 : Control annual grass and weeds on the levee slopes and easements.					
Inspector Comment

View of waterside slope looking downstream. (Spring 2019)
