**Flood Control Project Maintenance  
Levee Inspections**

## Maintenance Issue Types Only, Levee Inspection Report By Mile - Spring 2019

### Lower San Joaquin Levee District

Waterway	Bank	Unit Miles	Inspection Start/End	Inspector
Unit No. 01 San Joaquin River	Right	22.52	03/26/2019 03/26/2019	Corey Fujitani

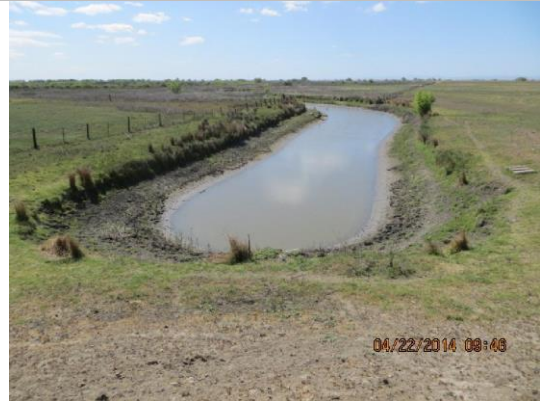
Photo 3 of 3 : UCIP\_SP\_2019\_39516\_62145.jpg

LM Start	0.30	Rating **	M	Issue No.	5 (cont)	
LM End	0.30	Issue Type +	Ma	Location *		
Category	Supplemental			GPS Latitude/Longitude		
				Start	End	
Item	DWR UCIP LMA Responsibility			37.219116°	37.219116°	
				-120.706652°	-120.706652°	
DWR ID	19845					
Comment Code						
Inspector Comment						
FS_ID:39516 DS_ID:19845 EP_NO: N/A Repair Type: Non-Urgent Crossing Status: Found UCIP Comments: 04/22/2014 Inlet blocked at LS toe by wooden gate. Need to contact owner to determine status. (DWR UCIP - W. Wylie) FIELD_STRUCT_DESC: 36-inch corrugated metal gravity drainage pipe through the levee, 19.6 feet below the crown. Slide gate in a 48-inch corrugated metal pipe (CMP) riser on the waterside (WS) slope. Concrete U-shaped headwall on each end. [Additional Reference(s): DWR Levee Log, 2002. USACE San Joaquin O&M Manual 601.1, 1967, (HLM 0.31)]. FS Date: 4/22/2014

Headwall and pipe on LS toe. Pipe blocked by wooden cover.

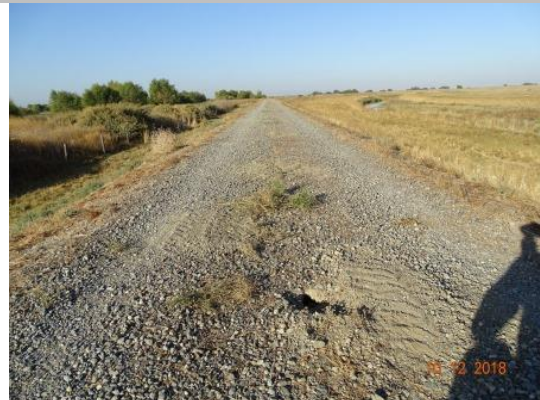
Photo 1 of 1 : SP\_2019\_NA0010\_128\_4\_20190307\_00001.jpg

LM Start	0.74	Rating **	A/W	Issue No.	4
LM End	0.76	Issue Type +	Ma	Location *	CR
Category	Earthen Levee			GPS Latitude/Longitude	
				Start	End
Item	Animal Control			37.219200 °	37.219258 °
				-120.699013 °	-120.698629 °
DWR ID	DWR_NA0010_10_f_2018_4				
Comment Code					
A3 : No rodents visible, but rodent burrows visible; need to backfill and compact or grout burrows.					
Inspector Comment					
There are rodent holes in the crown.

View of rodent holes in crown of the levee (Fall 2018)

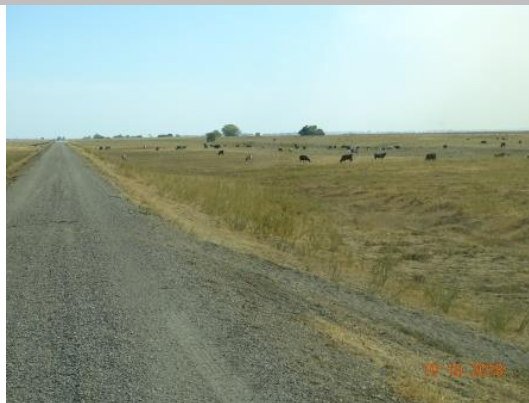
Photo 2 of 2 : SP\_2019\_NA0010\_129\_11\_20190307\_00005.jpg

View of damage on waterside. (Fall 2018)

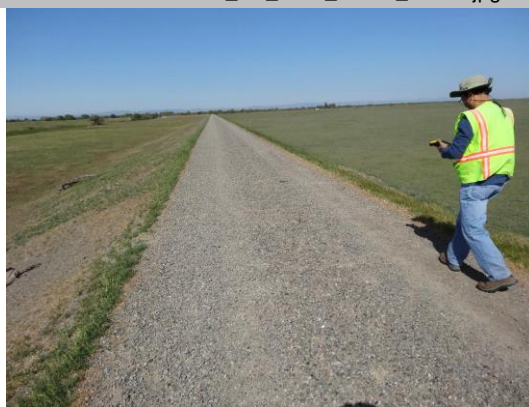
Photo 2 of 3 : UCIP\_SP\_2019\_39517\_66643.jpg

View of levee crown at crossing.

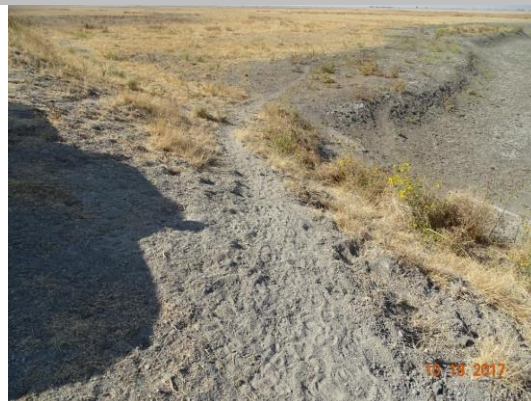
Photo 1 of 1 : SP\_2019\_NA0010\_129\_9\_20190307\_00001.jpg

LM Start	1.49	Rating **	M	Issue No.	9
LM End	1.49	Issue Type +	Ma	Location *	LS
Category	Earthen Levee			GPS Latitude/Longitude	
				Start	End
Item	Slope Stability			37.202748 °	37.202748 °
				-120.728182 °	-120.728182 °
DWR ID	DWR_NA0010_11_f_2017_9				
Comment Code					
S2 : Repair the levee slope damaged by foot traffic and prevent access where possible.					
Inspector Comment

Looking northwest at landside slope.

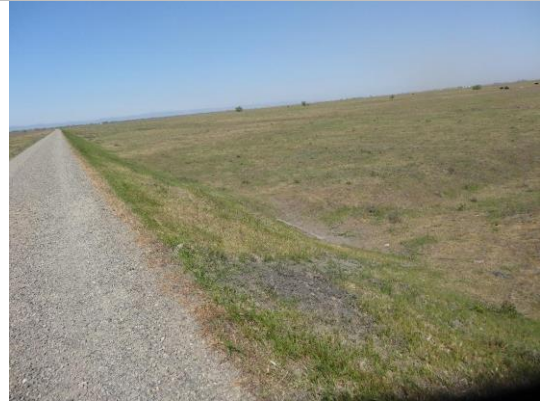
Photo 3 of 3 : UCIP\_SP\_2019\_39522\_62023.jpg

LM Start	1.98	Rating **	M	Issue No.	22 (cont)	
LM End	1.98	Issue Type +	Ma	Location *		
Category	Supplemental			GPS Latitude/Longitude		
				Start	End	
Item	DWR UCIP LMA Responsibility			37.202740 °	37.202740 °	
				-120.719247 °	-120.719247 °	
DWR ID	19851					
Comment Code						
Inspector Comment						
FS_ID:39522						
DS_ID:19851						
EP_NO: N/A						
Repair Type: Non-Urgent						
Crossing Status: Found						
UCIP Comments: 04/18/2014 Need to contact owner. Recommend clearing sediment deposit inside pipe. (DWR UCIP - O. Magana)						
FIELD_STRUCT_DESC: 24-inch corrugated metal gravity drainage pipe through the levee, 12.8 feet below the crown. Flap gate on the waterside (WS) end. [Additional Reference(s): DWR Levee Log, 2002. USACE San Joaquin O&M Manual 601.1, 1967, (HLM 1.99)].						
FS Date: 4/18/2014

View of landward side.

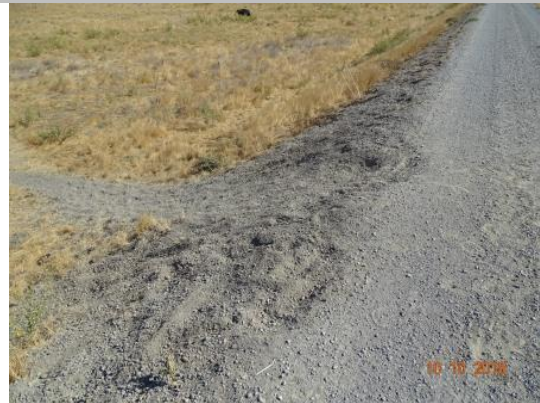
Photo 1 of 2 : SP\_2019\_NA0010\_129\_12\_20190307\_00006.jpg

LM Start	2.46	Rating **	M	Issue No.	12
LM End	2.46	Issue Type +	Ma	Location *	LS
Category	Earthen Levee			GPS Latitude/Longitude	
				Start	End
Item	Slope Stability			37.202712 °	37.202712 °
				-120.710633 °	-120.710633 °
DWR ID	DWR_NA0010_11_f_2018_12				
Comment Code					
S2 : Repair the levee slope damaged by foot traffic and prevent access where possible.					
Inspector Comment					
Damage is from livestock to both landside and waterside slopes.

View of landside slope. (Fall 2018)

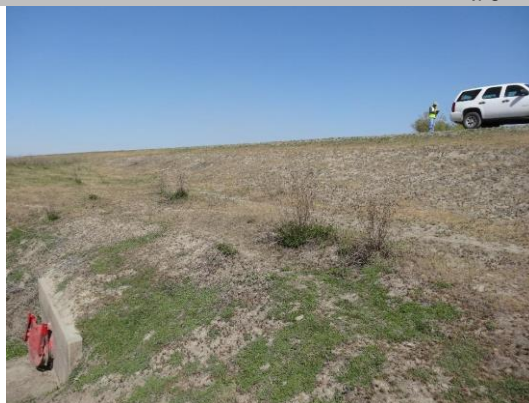
Photo 1 of 3 : UCIP\_SP\_2019\_39523\_62028.jpg

LM Start	3.04	Rating **	M	Issue No.	23	
LM End	3.04	Issue Type +	Ma	Location *		
Category	Supplemental			GPS Latitude/Longitude		
				Start	End	
Item	DWR UCIP LMA Responsibility			37.202494 °	37.202494 °	
				-120.700153 °	-120.700153 °	
DWR ID	19852					
Comment Code						
Inspector Comment						
FS_ID:39523 DS_ID:19852 EP_NO: N/A Repair Type: Non-Urgent Crossing Status: Found UCIP Comments: 04/18/2014 Need to contact owner. Recommend clearing sediment deposit inside pipe. (DWR UCIP - O. Magana) FIELD_STRUCT_DESC: 24-inch corrugated metal gravity drainage pipe through the levee, 15 feet below the crown. Flap gate on the waterside (WS) end. [Additional Reference(s): DWR Levee Log, 2002. USACE San Joaquin O&M Manual 601.1, 1967, (HLM 3.04)]. FS Date: 4/18/2014

Overview of waterward side--flap gate, concrete headwall and apron visible on levee toe.

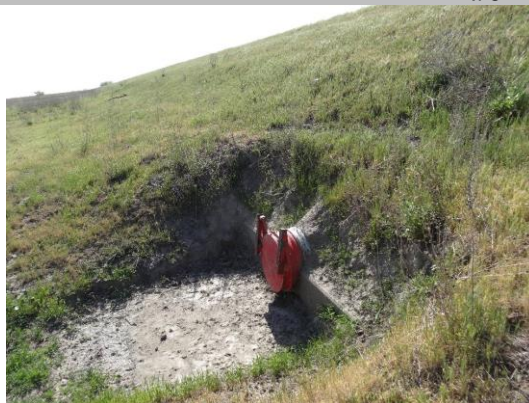
Photo 2 of 3 : UCIP\_SP\_2019\_36704\_66649.jpg

Comment Code						
Inspector Comment						
FS_ID:36704 DS_ID:19855 EP_NO: N/A Repair Type: Non-Urgent Crossing Status: Found UCIP Comments: 04/18/2014 Need to contact owner. Dense vegetation limits the inspector's visibility to identify signs of pipe failure (leaks) along the waterward slope. Recommend removing vegetation along pipe alignment to conduct proper inspection of structure. (DWR UCIP - O. Magana) FIELD_STRUCT_DESC: 24-inch corrugated metal gravity drainage pipe through the levee, 10.5 feet below the crown. Flap gate on the waterside (WS) end. [Additional Reference(s): DWR Levee Log, 2002. USACE San Joaquin O&M Manual 601.1, 1967, (HLM 0.39)]. FS Date: 4/18/2014

Concrete headwall and flap gate visible on waterward side.

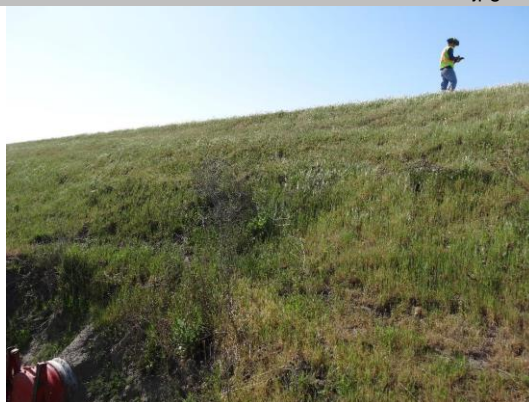
Photo 3 of 3 : UCIP\_SP\_2019\_36704\_66648.jpg

View of waterward side--medium grass throughout slope.

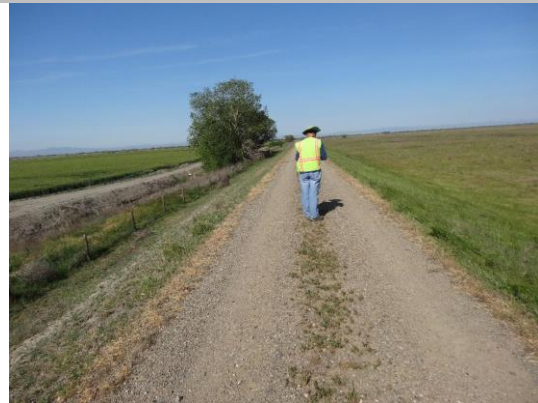
Photo 1 of 3 : UCIP\_SP\_2019\_36705\_66654.jpg

Comment Code						
Inspector Comment						
FS_ID:36705 DS_ID:19857 EP_NO: N/A Repair Type: Non-Urgent Crossing Status: Found UCIP Comments: 04/18/2014 Landward side not accessible due to dense vegetation and fence. Concrete headwall and flap gate under water therefore not able to evaluate condition. Will need to coordinate with owner to evaluate condition of crossing on waterward side and obtain access to evaluate landward side. (DWR UCIP - O. Magana) FIELD_STRUCT_DESC: 24-inch corrugated metal gravity drainage pipe through the levee, 17.4 feet below the crown. Flap gate on the waterside (WS) end. [Additional Reference(s): DWR Levee Log, 2002. USACE San Joaquin O&M Manual 601.1, 1967, (HLM 1.27)]. FS Date: 4/18/2014

Overview of levee crown at crossing.

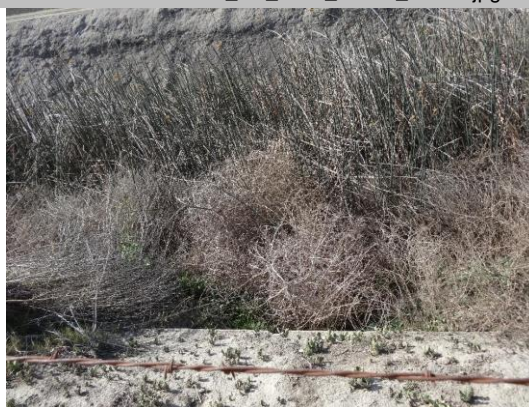
Photo 3 of 3 : UCIP\_SP\_2019\_39506\_62062.jpg

Dense vegetation on landward side--limited access due to fence along landward side.

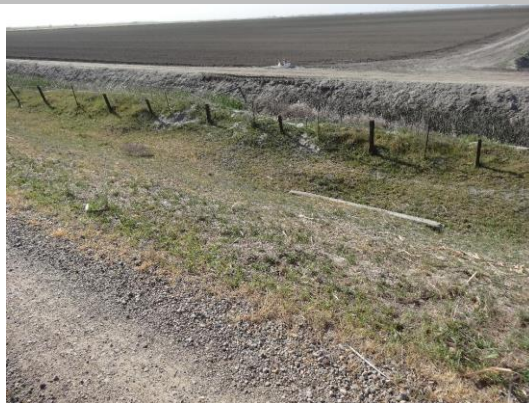
Photo 3 of 3 : UCIP\_SP\_2019\_39890\_62068.jpg

View of landward side.

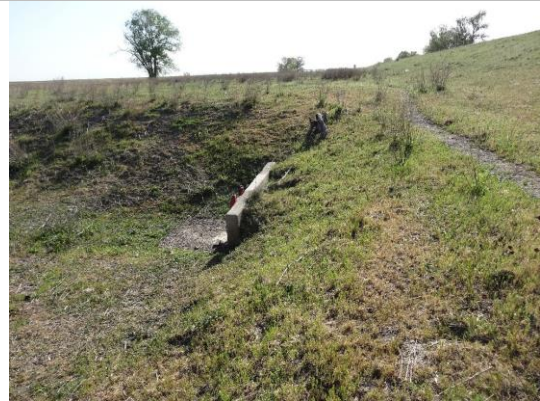
Photo 3 of 3 : UCIP\_SP\_2019\_46786\_62072.jpg

Comment Code						
Inspector Comment						
FS_ID:46786 DS_ID:19861 EP_NO: N/A Repair Type: Non-Urgent Crossing Status: Found UCIP Comments: 11/09/2015 DWR Inspection section confirmed issue has been addressed. Need to coordinate with LMA to determine additional details for extent of repair. 04/18/2014 Soil missing behind concrete headwall on waterward side. Unable to determine if missing soil is due to sink holes, rodent activity, or due to erosion. Headwall appears to be leaning slightly forward. Reason why this crossing was labelled urgent was due to the uncertainty of damage to concrete headwall and reason for soil missing behind concrete. Need to coordinate with LMA to determine more information about repair at this location. (DWR UCIP - O. Magana) FIELD_STRUCT_DESC: 24-inch corrugated metal gravity drainage pipe through the levee, 2 feet below the crown. Flap gate on the waterside (WS) end. [Additional Reference(s): DWR Levee Log, 2002. USACE San Joaquin O&M Manual 601.1, 1967, (HLM 3.00)]. FS Date: 11/10/2015 9:29:00 AM

Side view of concrete headwall which appears to be slightly slanted forward--missing soil behind headwall.

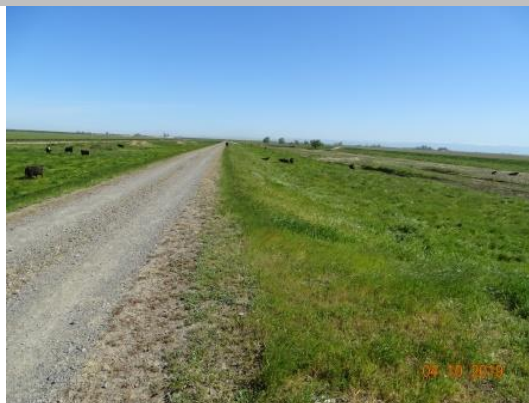
Photo 1 of 1 : SP\_2019\_NA0010\_131\_10\_20190426\_00019.jpg

LM Start	0.02	Rating **	M	Issue No.	10
LM End	1.26	Issue Type +	Ma	Location *	WS
Category	Earthen Levee			GPS Latitude/Longitude	
				Start	End
Item	Vegetation			37.033971 °	37.046304 °
				-120.442011 °	-120.428097 °
DWR ID	DWR_NA0010_13_s_2019_10				
Comment Code					
V1 : Control annual grass and weeds on the levee slopes and easements.					
Inspector Comment

View of waterside slope looking upstream. (Spring 2019)

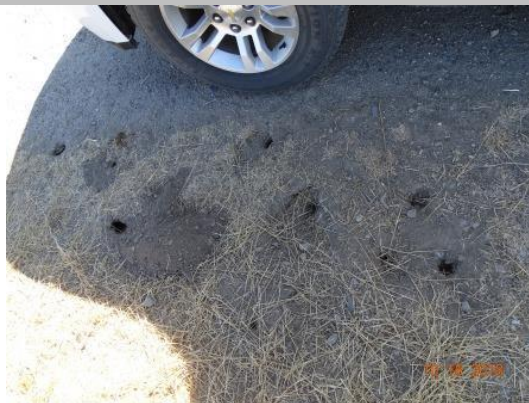
Photo 1 of 1 : SP\_2019\_NA0010\_131\_9\_20190307\_00012.jpg

LM Start	0.90	Rating **	M	Issue No.	9
LM End	0.90	Issue Type +	Ma	Location *	LS
Category	Earthen Levee			GPS Latitude/Longitude	
				Start	End
Item	Animal Control			37.044778 °	37.044778 °
				-120.434198 °	-120.434198 °
DWR ID	DWR_NA0010_13_f_2018_9				
Comment Code					
A3 : No rodents visible, but rodent burrows visible; need to backfill and compact or grout burrows.					
Inspector Comment

View of several rodent burrows in landside shoulder. (Fall 2018)

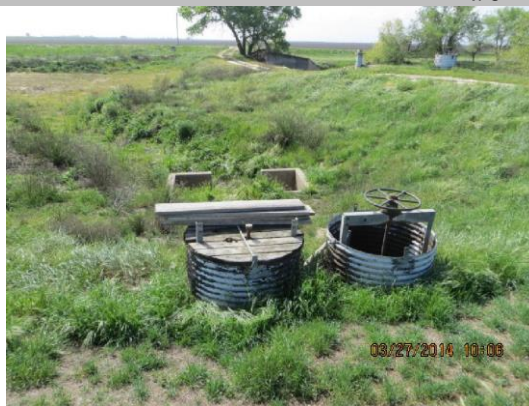
Photo 1 of 3 : UCIP\_SP\_2019\_39877\_59385.jpg

Comment Code						
Inspector Comment						
FS_ID:39877 DS_ID:19727 EP_NO: N/A Repair Type: Non-Urgent Crossing Status: Found UCIP Comments: 03/27/2014 Appears abandoned and if so should be done so properly. Pipe filled with soil on WS at outlet. Actuator missing from slide gate on WS shoulder. (DWR UCIP - W. Wylie) FIELD_STRUCT_DESC: [Rounder Irrigation Structure] 1 of 2: 36-inch corrugated metal gravity drainage pipe through the levee, 12.3 feet below the crown. Slide gate in a 48-inch corrugated metal pipe (CMP) riser on the waterside (WS) slope. 6-foot by 12-foot concrete distribution box on the landside (LS). 7-foot by 14-foot concrete outlet structure on the WS toe. [Additional Reference(s): DWR Levee Log, 2002. USACE San Joaquin O&M Manual 601.1, 1967, (HLM 1.14)]. FS Date: 3/27/2014

Slide gate in CMP riser on WS shoulder.

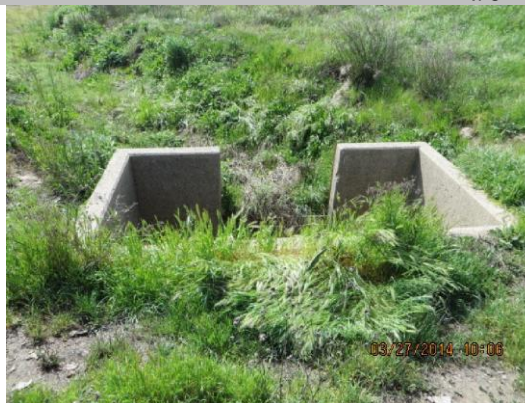
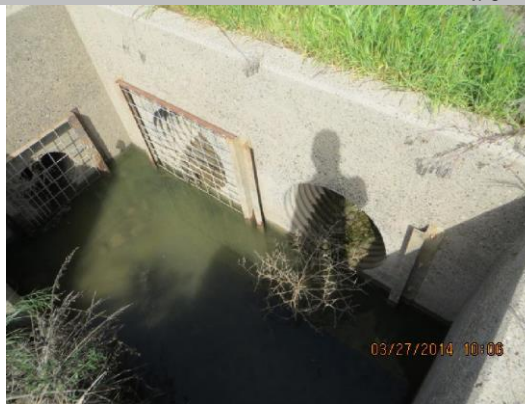
Photo 2 of 3 : UCIP\_SP\_2019\_39877\_59384.jpg

Comment Code						
Inspector Comment						
FS_ID:39877						
DS_ID:19727						
EP_NO: N/A						
Repair Type: Non-Urgent						
Crossing Status: Found						
UCIP Comments: 03/27/2014 Appears abandoned and if so should be done so properly. Pipe filled with soil on WS at outlet. Actuator missing from slide gate on WS shoulder. (DWR UCIP - W. Wylie)						
FIELD_STRUCT_DESC: [Rounder Irrigation Structure] 1 of 2: 36-inch corrugated metal gravity drainage pipe through the levee, 12.3 feet below the crown. Slide gate in a 48-inch corrugated metal pipe (CMP) riser on the waterside (WS) slope. 6-foot by 12-foot concrete distribution box on the landside (LS). 7-foot by 14-foot concrete outlet structure on the WS toe. [Additional Reference(s): DWR Levee Log, 2002. USACE San Joaquin O&M Manual 601.1, 1967, (HLM 1.14)].						
FS Date: 3/27/2014

Concrete box on WS toe.

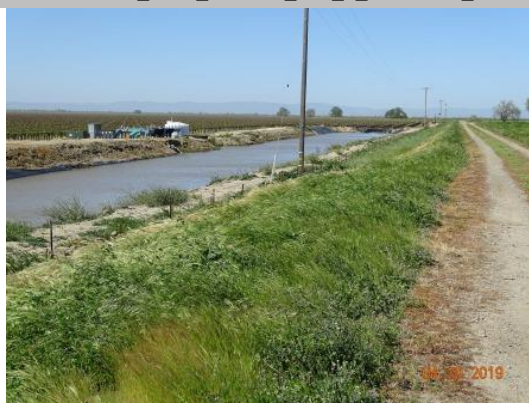
Photo 1 of 1 : SP\_2019\_NA0010\_132\_8\_20190426\_00011.jpg

LM Start	0.01	Rating **	U	Issue No.	8
LM End	1.26	Issue Type +	Ma	Location *	LS
Category	Earthen Levee			GPS Latitude/Longitude	
				Start	End
Item	Vegetation			37.032447 °	37.045405 °
				-120.441229 °	-120.427738 °
DWR ID	DWR_NA0010_14_s_2019_8				
Comment Code					
V1 : Control annual grass and weeds on the levee slopes and easements.					
Inspector Comment

View of landside slope looking downstream. (Spring 2019)

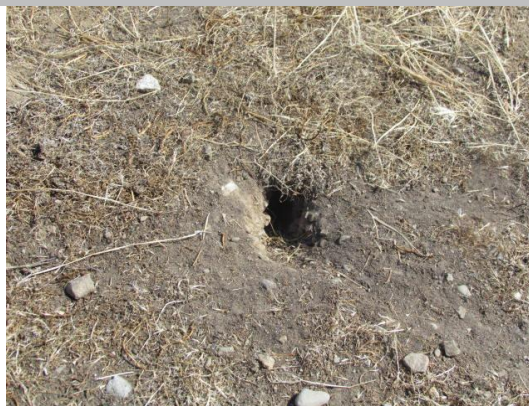
Photo 1 of 1 : SP\_2019\_NA0010\_132\_79\_20190307\_00003.jpg

LM Start	1.24	Rating **	M	Issue No.	79
LM End	1.24	Issue Type +	Ma	Location *	LS
Category	Earthen Levee			GPS Latitude/Longitude	
				Start	End
Item	Animal Control			37.045343 °	37.045343 °
				-120.428007 °	-120.428007 °
DWR ID	DWR_NA0010_14_s_2015_79				
Comment Code					
A3 : No rodents visible, but rodent burrows visible; need to backfill and compact or grout burrows.					
Inspector Comment					
Several rodent holes are noted on the landside at this location.

Looking at typical view of rodent holes on landward slope.

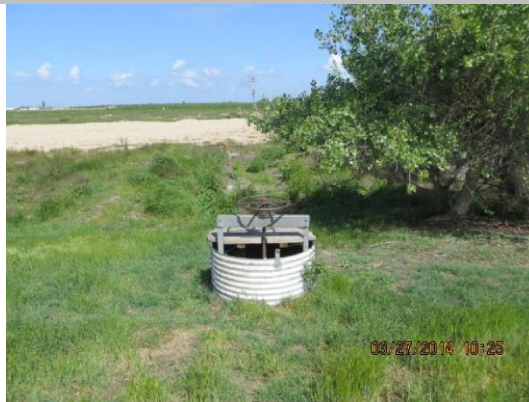
LM Start	1.26	Rating **	A/W	Issue No.	81
LM End	1.26	Issue Type +	Ma	Location *	
Category	Supplemental			GPS Latitude/Longitude	
				Start	End
Item	DWR UCIP LMA Responsibility		37.045383 °	37.045383 °	
			-120.427754 °	-120.427754 °	
DWR ID	19910				
Comment Code					
Inspector Comment					
FS_ID:32828 DS_ID:19910 EP_NO: N/A Repair Type: No Action Needed Crossing Status: Found UCIP Comments: FIELD_STRUCT_DESC: 36-inch corrugated metal gravity drainage pipe through the levee, 9 feet below the crown. Slide gate in a 42-inch corrugated metal pipe (CMP) riser on the waterside (WS) slope. Concrete U-shaped headwall on the WS end. Pipe terminates into a concrete ditch on the landside (LS). [Additional Reference(s): DWR Levee Log, 2002. USACE San Joaquin O&M Manual 601.1, 1967, (HLM 1.26)]. FS Date: 3/27/2014

Concrete U-shaped headwall on Ws toe.

slidegate in CMP riser on WS slope.

Inlet assumed to be within irrigation structure off LS toe.

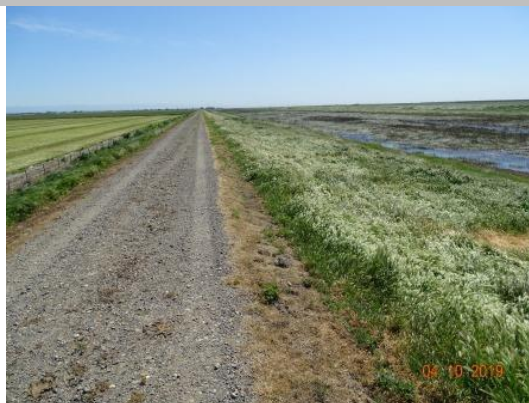
Photo 1 of 1 : SP\_2019\_NA0010\_133\_7\_20190426\_00014.jpg

LM Start	0.02	Rating **	M	Issue No.	7
LM End	0.82	Issue Type +	Ma	Location *	WS
Category	Earthen Levee			GPS Latitude/Longitude	
				Start	End
Item	Vegetation			36.996550 °	36.996551 °
				-120.409977 °	-120.395523 °
DWR ID	DWR_NA0010_15_f_2018_7				
Comment Code					
V1 : Control annual grass and weeds on the levee slopes and easements.					
Inspector Comment

View of waterside slope looking upstream. (Spring 2019)

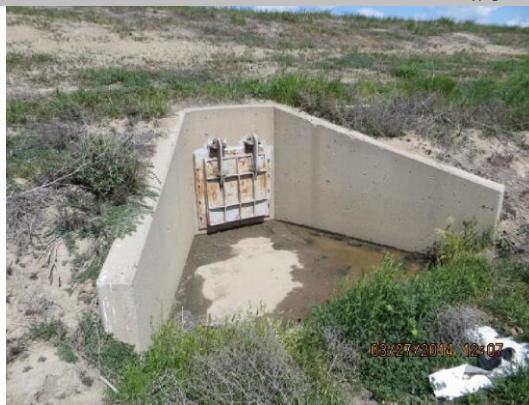
LM Start	0.48	Rating **	A/W	Issue No.	13
LM End	0.48	Issue Type +	Ma	Location *	
Category	Supplemental			GPS Latitude/Longitude	
				Start	End
Item	DWR UCIP LMA Responsibility			36.996551 °	36.996551 °
				-120.401737 °	-120.401737 °
DWR ID	19911				
Comment Code					
Inspector Comment					
FS_ID:32838 DS_ID:19911 EP_NO: N/A Repair Type: No Action Needed Crossing Status: Found UCIP Comments: FIELD_STRUCT_DESC: 30-inch by 30-inch square reinforced concrete box gravity drainage culvert through the levee, 10.1 feet below the crown. Flap gate on the waterside (WS) end. Concrete headwall on the landside (LS) end. Concrete U-shaped headwall on the WS end. [Additional Reference(s): DWR Levee Log, 2002. USACE San Joaquin O&M Manual 601.1, 1967, (HLM 0.48)]. FS Date: 3/27/2014

Concrete headwall on WS toe.

Flapgate on Concrete headwall at WS toe.

Concrete headwall on LS toe.

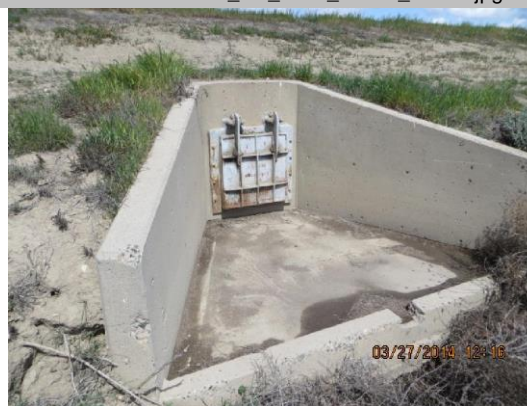
Comment Code						
Inspector Comment						
FS_ID:39527						
DS_ID:19912						
EP_NO: N/A						
Repair Type: Non-Urgent						
Crossing Status: Found						
UCIP Comments: 03/27/2014 Dense vegetation limits the inspector's visibility to identify signs of pipe failure (leaks) along the landward slope. Recommend removing vegetation along pipe alignment to conduct proper inspection of structure. (DWR UCIP - W. Wylie)						
FIELD_STRUCT_DESC: 30-inch by 30-inch square reinforced concrete box gravity drainage culvert through the levee, 8.5 feet below the crown. Flap gate on the waterside (WS) end. Concrete headwall on the landside (LS) end. Concrete U-shaped headwall on the WS end.						
[Additional Reference(s): DWR Levee Log, 2002. USACE San Joaquin O&M Manual 601.1, 1967, (HLM 1.01)].						
FS Date: 3/27/2014

Concrete headwall on WS toe.

Flapgate on concrete headwall at WS toe.

Concrete headwall on LS toe.

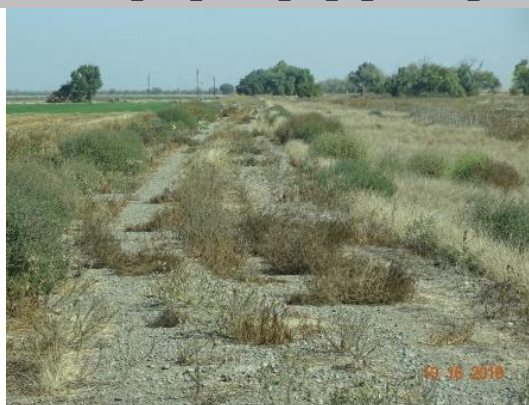
Photo 1 of 1 : SP\_2019\_NA0010\_133\_12\_20190307\_00004.jpg

LM Start	1.51	Rating **	M	Issue No.	12
LM End	2.02	Issue Type +	Ma	Location *	CR
Category	Earthen Levee			GPS Latitude/Longitude	
				Start	End
Item	Vegetation			36.996562 °	36.996586 °
				-120.383121 °	-120.373850 °
DWR ID	DWR_NA0010_15_f_2018_12				
Comment Code					
V9 : Keep the crown roadway free of vegetation.					
Inspector Comment					
Vegetation on levee crown should be removed.

View of moderate vegetation on levee crown. (Fall 2018)

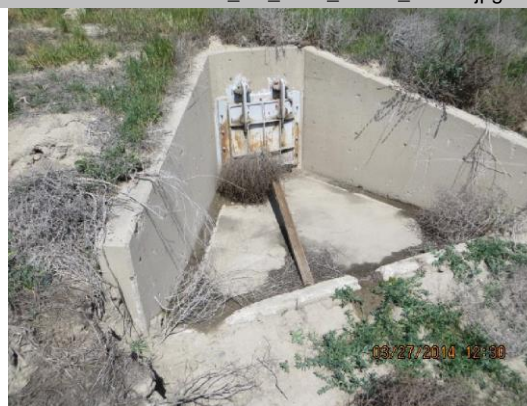
Photo 2 of 3 : UCIP\_SP\_2019\_32840\_59457.jpg

Flapgate on concrete headwall at WS toe.

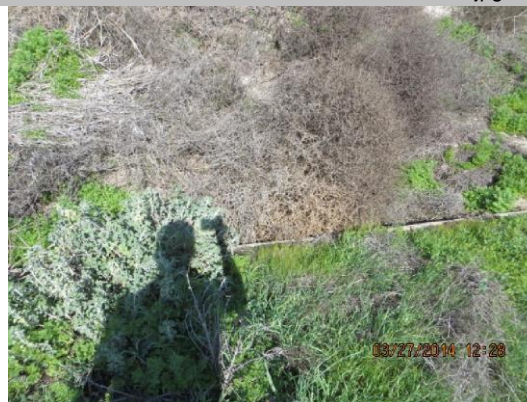
Photo 3 of 3 : UCIP\_SP\_2019\_32840\_59455.jpg

Concrete headwall on LS toe. Note excessive vegetation buildup.

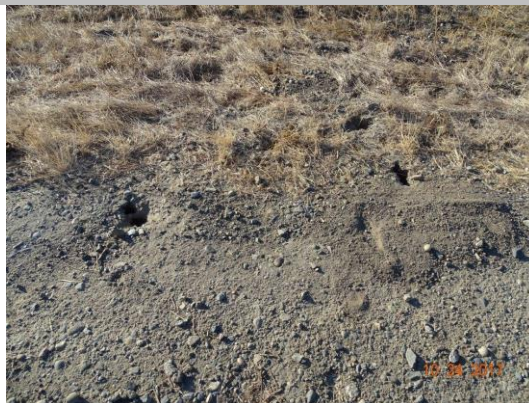
Photo 1 of 1 : SP\_2019\_NA0010\_133\_6\_20190307\_00001.jpg

LM Start	1.58	Rating **	M	Issue No.	6
LM End	2.01	Issue Type +	Ma	Location *	CR
Category	Earthen Levee			GPS Latitude/Longitude	
				Start	End
Item	Animal Control			36.996563 °	36.996578 °
				-120.381895 °	-120.374111 °
DWR ID	DWR_NA0010_15_f_2017_6				
Comment Code					
A3 : No rodents visible, but rodent burrows visible; need to backfill and compact or grout burrows.					
Inspector Comment

Representative picture of the crown.

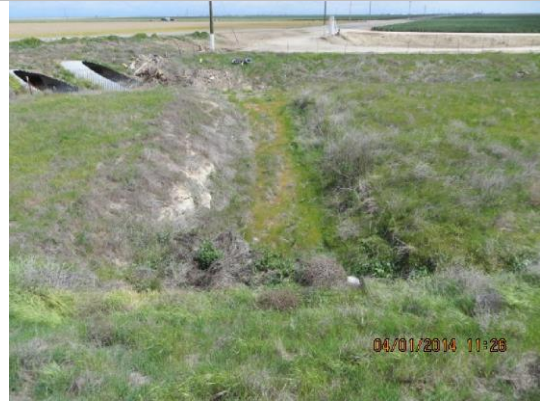
Photo 3 of 3 : UCIP\_SP\_2019\_39531\_59709.jpg

Comment Code						
Inspector Comment						
FS_ID:39531 DS_ID:19916 EP_NO: N/A Repair Type: Non-Urgent Crossing Status: Found UCIP Comments: 04/01/2014 Dense vegetation limits the inspector's visibility to identify signs of pipe failure (leaks) along the landward slope. Recommend removing vegetation along pipe alignment to conduct proper inspection of structure. (DWR UCIP - W. Wylie) FIELD_STRUCT_DESC: 48-inch by 60-inch reinforced concrete box gravity drainage culvert through the levee, 14.6 feet below the crown. Flap gate on the waterside (WS) end. Concrete headwall on the landside (LS) end. Concrete U-shaped headwall on the WS end. [Additional Reference(s): DWR Levee Log, 2002. USACE San Joaquin O&M Manual 601.1, 1967, (HLM 2.58)]. FS Date: 4/1/2014

Concrete headwall at LS toe.

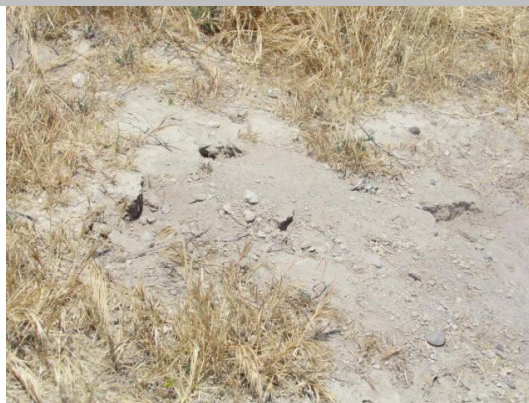
Photo 1 of 2 : SP\_2019\_NA0010\_135\_8\_20190307\_00005.jpg

LM Start	5.75	Rating **	M	Issue No.	8
LM End	5.90	Issue Type +	Ma	Location *	LS
Category	Earthen Levee			GPS Latitude/Longitude	
				Start	End
Item	Animal Control			36.908605 °	36.906507 °
				-120.331112 °	-120.330353 °
DWR ID	DWR_NA0010_17_s_2012_8				
Comment Code					
A1 : Exterminate rodents and backfill and compact or grout burrows.					
Inspector Comment					
Multiple rodent holes are noted on the landside slope.

Looking at several rodent holes on landward slope. (Spring 2015)

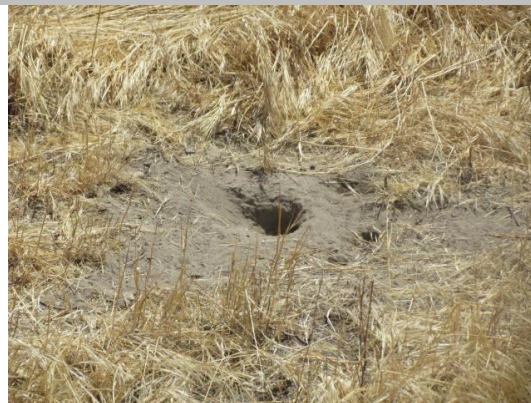
Photo 1 of 1 : SP\_2019\_NA0010\_135\_4\_20190307\_00003.jpg

LM Start	6.51	Rating **	M	Issue No.	4
LM End	6.72	Issue Type +	Ma	Location *	LS
Category	Earthen Levee			GPS Latitude/Longitude	
				Start	End
Item	Animal Control			36.898093 °	36.895300 °
				-120.326689 °	-120.325322 °
DWR ID	DWR_NA0010_17_s_2012_4				
Comment Code					
A1 : Exterminate rodents and backfill and compact or grout burrows.					
Inspector Comment					
Several rodent holes are identified within this reach.

Looking at typical view of rodent holes on landward slope.

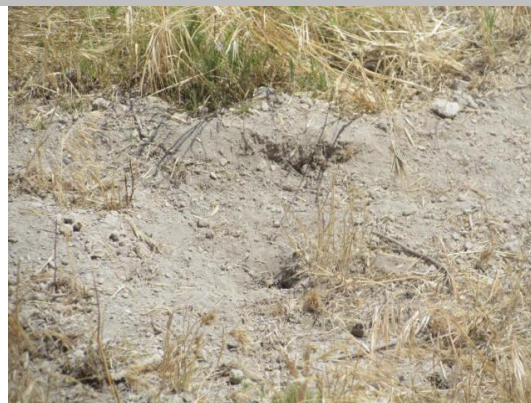
Photo 1 of 1 : SP\_2019\_NA0010\_135\_5\_20190307\_00004.jpg

LM Start	7.27	Rating **	M	Issue No.	5
LM End	7.38	Issue Type +	Ma	Location *	LS
Category	Earthen Levee			GPS Latitude/Longitude	
				Start	End
Item	Animal Control			36.887852 °	36.886388 °
				-120.321668 °	-120.320950 °
DWR ID	DWR_NA0010_17_s_2012_5				
Comment Code					
A3 : No rodents visible, but rodent burrows visible; need to backfill and compact or grout burrows.					
Inspector Comment					
Several rodent holes are identified within this reach.

Looking at typical view of rodent holes on landward slope.

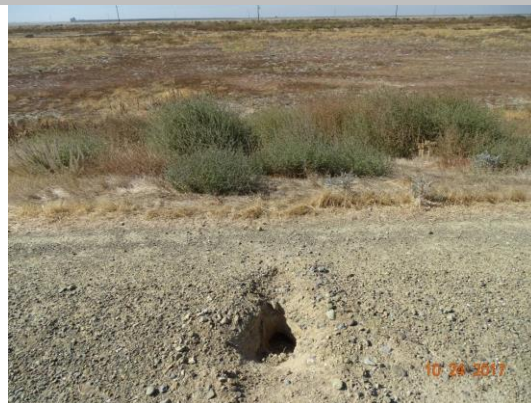
Photo 1 of 1 : SP\_2019\_NA0010\_135\_23\_20190307\_00013.jpg

LM Start	7.41	Rating **	M	Issue No.	23
LM End	7.41	Issue Type +	Ma	Location *	CR
Category	Earthen Levee			GPS Latitude/Longitude	
				Start	End
Item	Animal Control			36.885998 °	36.885998 °
				-120.320759 °	-120.320759 °
DWR ID	DWR_NA0010_17_f_2017_23				
Comment Code					
A3 : No rodents visible, but rodent burrows visible; need to backfill and compact or grout burrows.					
Inspector Comment

Looking southwest at the crown.

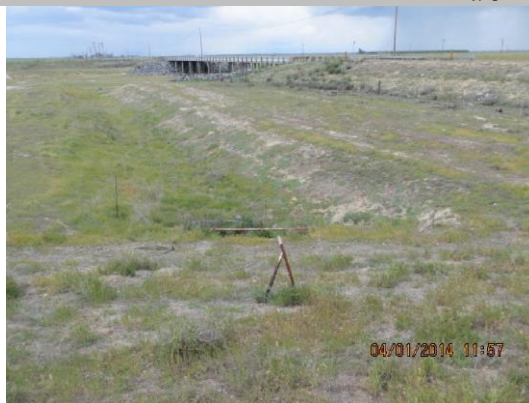
Photo 1 of 3 : UCIP\_SP\_2019\_32999\_59718.jpg

LM Start	8.37	Rating **	A/W	Issue No.	41
LM End	8.37	Issue Type +	Ma	Location *	
Category	Supplemental			GPS Latitude/Longitude	
				Start	End
Item	DWR UCIP LMA Responsibility			36.872358 °	36.872358 °
				-120.317170 °	-120.317170 °
DWR ID	19922				
Comment Code					
Inspector Comment					
FS_ID:32999					
DS_ID:19922					
EP_NO: N/A					
Repair Type: No Action Needed					
Crossing Status: Found					
UCIP Comments:					
FIELD_STRUCT_DESC: 48-inch by 60-inch reinforced concrete box gravity drainage culvert through the levee, 16.5 feet below the crown. Flap gate on the waterside (WS) end. Concrete headwall on the landside (LS) end. Concrete U-shaped headwall on the WS end. [Additional Reference(s): DWR Levee Log, 2002. USACE San Joaquin O&M Manual 601.1, 1967, (HLM 8.38)].					
FS Date: 4/1/2014

Concrete headwall and channel on WS toe.

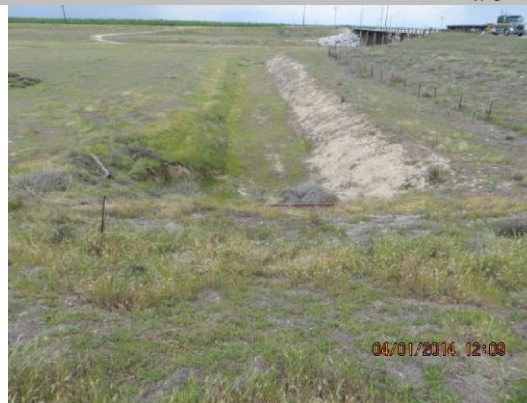
Photo 1 of 3 : UCIP\_SP\_2019\_39532\_59723.jpg

Comment Code					
Inspector Comment					
FS_ID:39532					
DS_ID:19917					
EP_NO: N/A					
Repair Type: Non-Urgent					
Crossing Status: Found					
UCIP Comments: 04/01/2014 Dense vegetation limits the inspector's visibility to identify signs of pipe failure (leaks) along the landward slope. Recommend removing vegetation along pipe alignment to conduct proper inspection of structure. (DWR UCIP - W. Wylie)					
FIELD_STRUCT_DESC: 48-inch by 60-inch reinforced concrete box gravity drainage culvert through the levee, 15 feet below the crown. Concrete headwall on the landside (LS) end. Concrete U-shaped headwall on the waterside (WS) end. [Additional Reference(s): DWR Levee Log, 2002. USACE San Joaquin O&M Manual 601.1, 1967, (HLM 9.89)].					
FS Date: 4/1/2014

Concrete headwall and channel on WS toe.

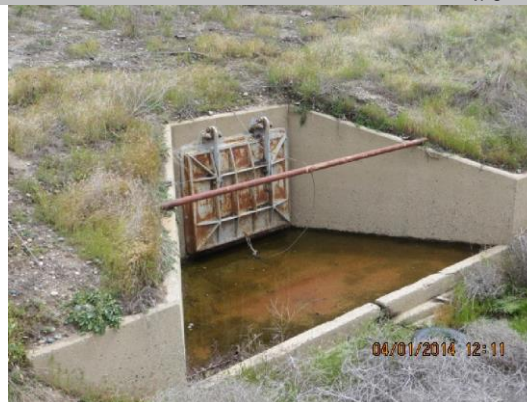
Photo 2 of 3 : UCIP\_SP\_2019\_39532\_59724.jpg

Flapgate on Concrete headwall at WS toe.

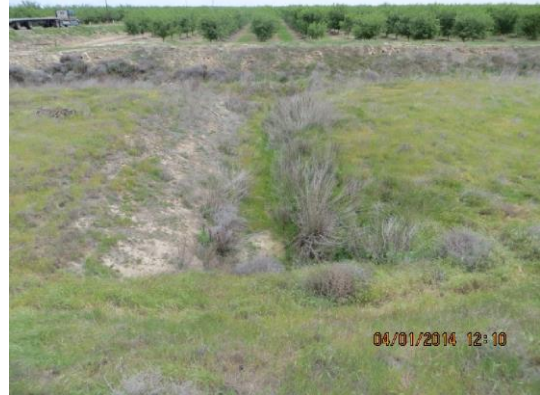
Photo 3 of 3 : UCIP\_SP\_2019\_39532\_59722.jpg

Comment Code						
Inspector Comment						
FS_ID:39532 DS_ID:19917 EP_NO: N/A Repair Type: Non-Urgent Crossing Status: Found UCIP Comments: 04/01/2014 Dense vegetation limits the inspector's visibility to identify signs of pipe failure (leaks) along the landward slope. Recommend removing vegetation along pipe alignment to conduct proper inspection of structure. (DWR UCIP - W. Wylie) FIELD_STRUCT_DESC: 48-inch by 60-inch reinforced concrete box gravity drainage culvert through the levee, 15 feet below the crown. Concrete headwall on the landside (LS) end. Concrete U-shaped headwall on the waterside (WS) end. [Additional Reference(s): DWR Levee Log, 2002. USACE San Joaquin O&M Manual 601.1, 1967, (HLM 9.89)]. FS Date: 4/1/2014

Concrete headwall and channel on LS toe.

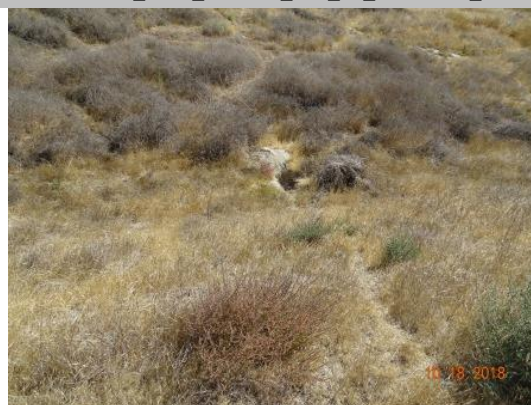
Photo 1 of 2 : SP\_2019\_NA0010\_135\_39\_20190307\_00027.jpg

LM Start	12.17	Rating **	U	Issue No.	39	
LM End	12.17	Issue Type +	Ma	Location *	LS	
Category	Earthen Levee			GPS Latitude/Longitude		
				Start		End
Item	Animal Control			36.822818 °		36.822818 °
				-120.299680 °		-120.299680 °
DWR ID	DWR_NA0010_17_f_2018_39					
Comment Code						
A3 : No rodents visible, but rodent burrows visible; need to backfill and compact or grout burrows.						
Inspector Comment						
A large hole is on the landside toe.

Large rodent hole at toe of levee. (Fall 2018)

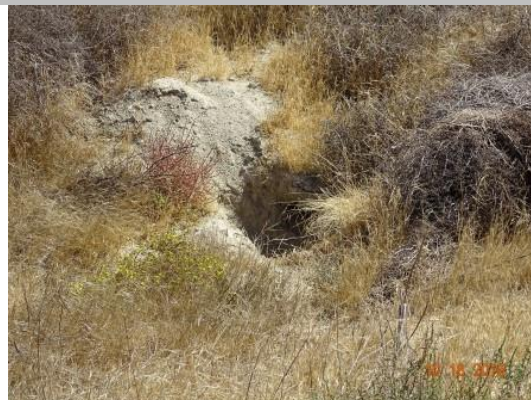
Photo 2 of 2 : SP\_2019\_NA0010\_135\_39\_20190307\_00028.jpg

Upclose view of rodent hole. (Fall 2018)

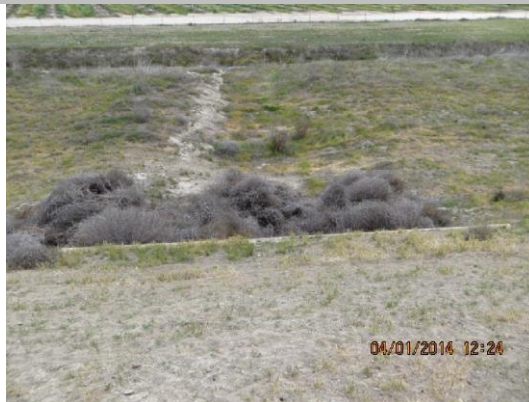
Photo 2 of 3 : UCIP\_SP\_2019\_39533\_59726.jpg

Concrete headwall on LS toe.

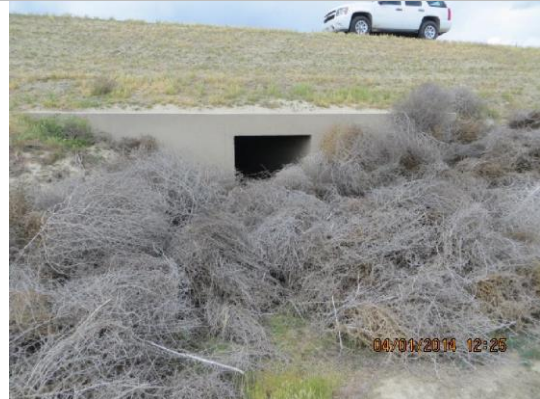
### Lower San Joaquin Levee District

LM Start	13.29	Rating **	M	Issue No.	43 (cont)
LM End	13.29	Issue Type +	Ma	Location *	
Category	Supplemental			GPS Latitude/Longitude	
				Start	End
Item	DWR UCIP LMA Responsibility			36.807509 °	36.807509 °
				-120.306231 °	-120.306231 °
DWR ID	19918				
Comment Code					
Inspector Comment					
FS_ID:39533 DS_ID:19918 EP_NO: N/A Repair Type: Non-Urgent Crossing Status: Found UCIP Comments: 04/01/2014 Some vegetation buildup at inlet--recommend clearing. (DWR UCIP - W. Wylie) FIELD_STRUCT_DESC: 48-inch by 60-inch reinforced concrete box gravity drainage culvert through the levee, 15.3 feet below the crown. Flap gate on the waterside (WS) end. Concrete headwall on the landside (LS) end. Concrete U-shaped headwall on the WS end. [Additional Reference(s): DWR Levee Log, 2002. USACE San Joaquin O&M Manual 601.1, 1967, (HLM 13.30)]. FS Date: 4/1/2014

Concrete headwall on LS toe. Some vegetation buildup.

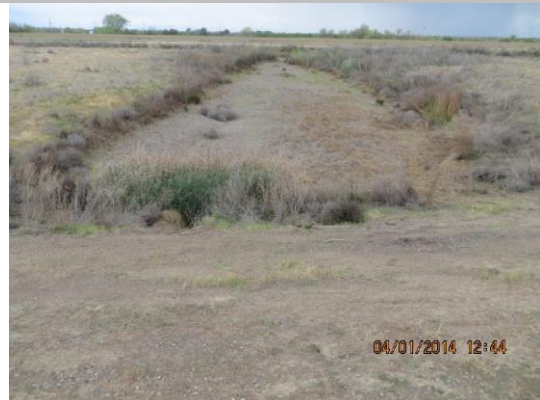
Photo 1 of 3 : UCIP\_SP\_2019\_39535\_59745.jpg

Comment Code					
Inspector Comment					
FS_ID:39535					
DS_ID:19920					
EP_NO: N/A					
Repair Type: Non-Urgent					
Crossing Status: Found					
UCIP Comments: 04/01/2014 Heavy vegetation buildup at LS toe--					
recommend clearing. (DWR UCIP - W. Wylie)					
FIELD_STRUCT_DESC: 30-inch by 30-inch square reinforced concrete					
box gravity drainage culvert through the levee, 14 feet below the crown.					
Flap gate on the waterside (WS) end. Concrete headwall on the					
landside (LS) end. Concrete U-shaped headwall on the WS end.					
[Additional Reference(s): DWR Levee Log, 2002. USACE San Joaquin					
O&M Manual 601.1, 1967, (HLM 14.69)].					
FS Date: 4/1/2014

Concrete headwall at WS toe.

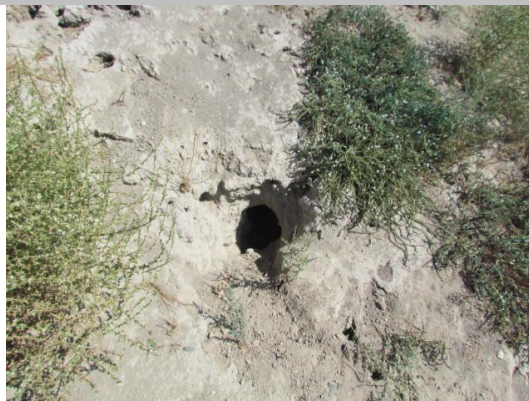
Photo 1 of 2 : SP\_2019\_NA0010\_137\_8\_20190307\_00003.jpg

LM Start	2.25	Rating **	U	Issue No.	8
LM End	2.25	Issue Type +	Ma	Location *	LS
Category	Earthen Levee			GPS Latitude/Longitude	
				Start	End
Item	Animal Control			36.945563 °	36.945563 °
				-120.347121 °	-120.347121 °
DWR ID	DWR_NA0010_18_f_2015_8				
Comment Code					
A3 : No rodents visible, but rodent burrows visible; need to backfill and compact or grout burrows.					
Inspector Comment					
There is one large rodent hole and other smaller rodent holes within this area.

Looking at large rodent hole on landward slope.

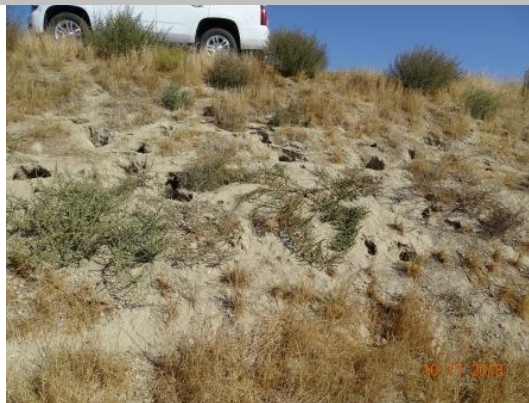
Photo 1 of 1 : SP\_2019\_NA0010\_137\_47\_20190307\_00022.jpg

LM Start	5.77	Rating **	U	Issue No.	47
LM End	5.77	Issue Type +	Ma	Location *	LS
Category	Earthen Levee			GPS Latitude/Longitude	
				Start	End
Item	Animal Control			36.896839 °	36.896839 °
				-120.328434 °	-120.328434 °
DWR ID	DWR_NA0010_18_f_2018_47				
Comment Code					
A3 : No rodents visible, but rodent burrows visible; need to backfill and compact or grout burrows.					
Inspector Comment

Several rodent holes in the landside slope. (Fall 2018)

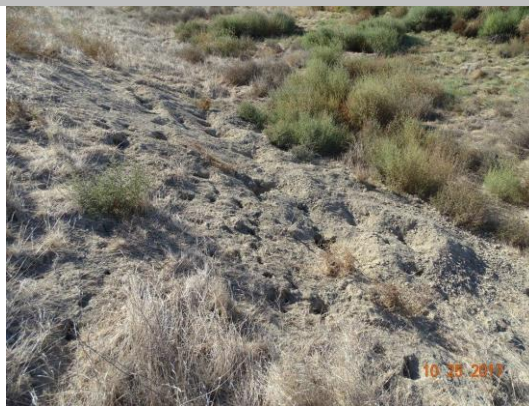
Photo 1 of 1 : SP\_2019\_NA0010\_137\_1\_20190307\_00001.jpg

LM Start	5.89	Rating **	U	Issue No.	1
LM End	5.89	Issue Type +	Ma	Location *	LS
Category	Earthen Levee			GPS Latitude/Longitude	
				Start	End
Item	Animal Control			36.895175 °	36.895175 °
				-120.327632 °	-120.327632 °
DWR ID	DWR_NA0010_18_s_2015_1				
Comment Code					
A3 : No rodents visible, but rodent burrows visible; need to backfill and compact or grout burrows.					
Inspector Comment					
There are several large rodent holes noted on the landside slope and berm within this section.

Looking at the landside slope.

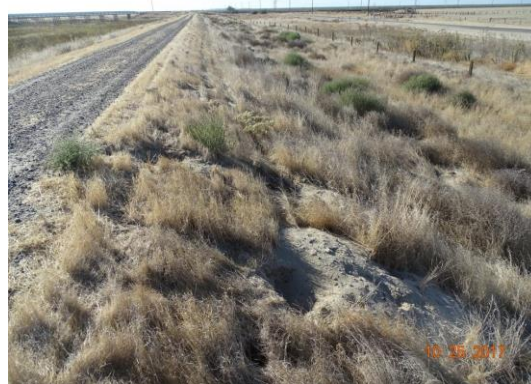
Photo 1 of 1 : SP\_2019\_NA0010\_137\_14\_20190307\_00006.jpg

LM Start	7.39	Rating **	U	Issue No.	14
LM End	7.53	Issue Type +	Ma	Location *	LS
Category	Earthen Levee			GPS Latitude/Longitude	
				Start	End
Item	Animal Control			36.874479 °	36.872503 °
				-120.319831 °	-120.319438 °
DWR ID	DWR_NA0010_18_f_2017_14				
Comment Code					
A3 : No rodents visible, but rodent burrows visible; need to backfill and compact or grout burrows.					
Inspector Comment					
There are several rodent holes noted along the landside slope in this area.

Looking south at the landside slope.

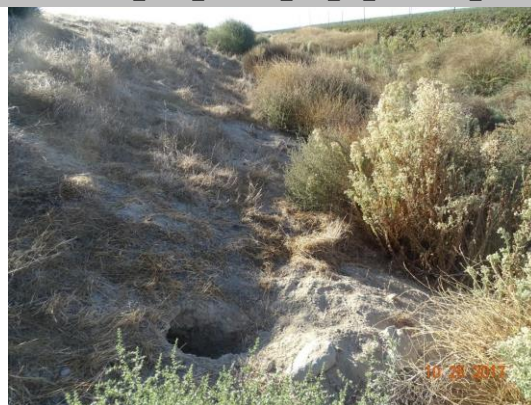
Photo 1 of 1 : SP\_2019\_NA0010\_137\_13\_20190307\_00005.jpg

LM Start	8.67	Rating **	U	Issue No.	13
LM End	8.67	Issue Type +	Ma	Location *	LS
Category	Earthen Levee			GPS Latitude/Longitude	
				Start	End
Item	Animal Control			36.856115 °	36.856115 °
				-120.316595 °	-120.316595 °
DWR ID	DWR_NA0010_18_f_2017_13				
Comment Code					
A3 : No rodents visible, but rodent burrows visible; need to backfill and compact or grout burrows.					
Inspector Comment

Looking south at the landside slope.

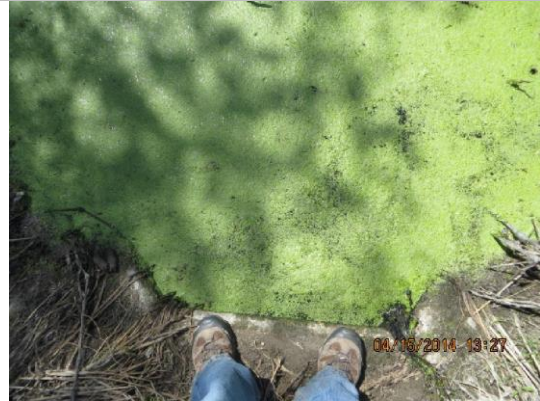
Photo 3 of 3 : UCIP\_SP\_2019\_49959\_61059.jpg

Comment Code						
Inspector Comment						
FS_ID:49959 DS_ID:19933 EP_NO: N/A Repair Type: Non-Urgent Crossing Status: Found UCIP Comments: 07/19/2016 Gate inside riser appears operable--riser lid damage. Crossing is not visible on LS due to dense vegetation. Recommend clearing dense vegetation along WS and LS slope and repairing riser cover. (DWR UCIP - omagana)04/15/2014 No actuator wheel on slide gate at WS shoulder. (DWR UCIP - wwylie) FIELD_STRUCT_DESC: 24-inch corrugated metal gravity drainage pipe through the levee, 14.8 feet below the crown. Slide gate in a 36-inch corrugated metal pipe (CMP) riser on the waterside (WS) slope. Concrete U-shaped headwall on each end. [Additional Reference(s): DWR Levee Log, 2002. USACE San Joaquin O&M Manual 601.1, 1967, (HLM 0.10)]. FS Date: 7/19/2016

Concrete headwall at LS toe.

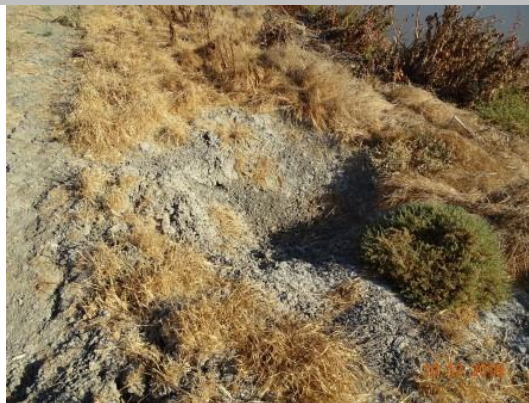
Photo 1 of 1 : SP\_2019\_NA0010\_138\_22\_20190307\_00021.jpg

LM Start	1.04	Rating **	M	Issue No.	22
LM End	1.04	Issue Type +	Ma	Location *	WS
Category	Earthen Levee			GPS Latitude/Longitude	
				Start	End
Item	Erosion / Bank Caving			37.220281 °	37.220281 °
				-120.698287 °	-120.698287 °
DWR ID	DWR_NA0010_22A_f_2018_22				
Comment Code					
E1 : Note and monitor erosion site.					
Inspector Comment					
Depressions are noted on waterside slope.

View of depression on waterside slope. (Fall 2018)

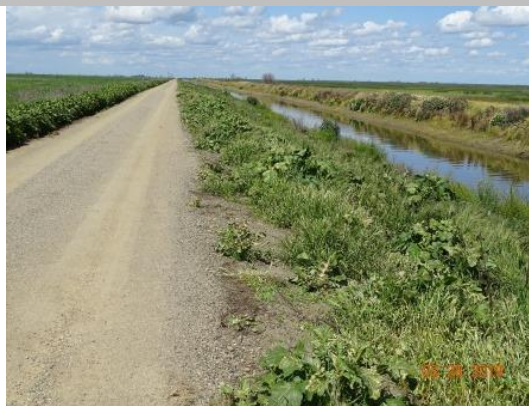
Photo 1 of 1 : SP\_2019\_NA0010\_138\_17\_20190418\_00050.jpg

LM Start	1.05	Rating **	U	Issue No.	17
LM End	1.23	Issue Type +	Ma	Location *	WS
Category	Earthen Levee			GPS Latitude/Longitude	
				Start	End
Item	Vegetation			37.220349 °	37.222864 °
				-120.698310 °	-120.699231 °
DWR ID	DWR_NA0010_22A_s_2019_17				
Comment Code					
V1 : Control annual grass and weeds on the levee slopes and easements.					
Inspector Comment

View of waterside slope looking downstream. (Spring 2019)

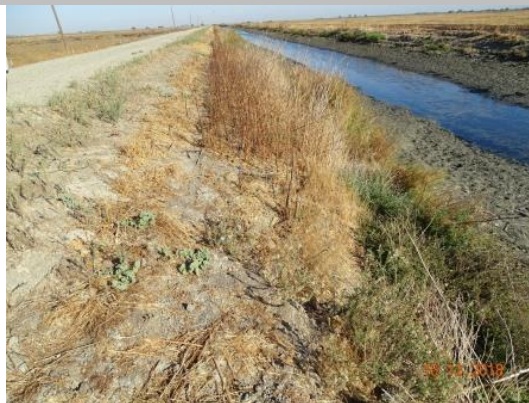
Photo 2 of 2 : SP\_2019\_NA0010\_138\_29\_20190307\_00026.jpg

LM Start	2.20	Rating **	M	Issue No.	29 (cont)	
LM End	2.37	Issue Type +	Ma	Location *	WS	
Category	Earthen Levee			GPS Latitude/Longitude		
				Start		End
Item	Erosion / Bank Caving			37.236392 °	37.238776 °	
				-120.704165 °	-120.705028 °	
DWR ID	DWR_NA0010_22A_f_2018_29					
Comment Code						
E1 : Note and monitor erosion site.						
Inspector Comment						
There is slope erosion from livestock, the slope is no longer 3:1.

Looking downstream along waterside slope. (Fall 2018)

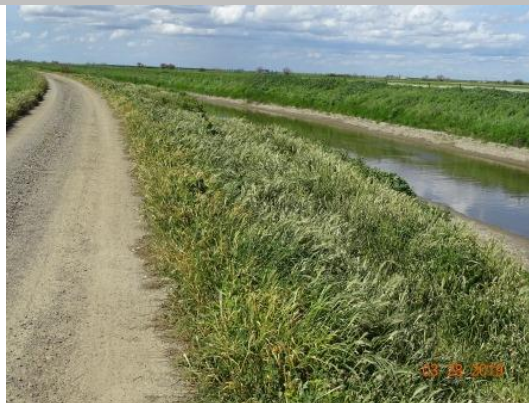
Photo 1 of 1 : SP\_2019\_NA0010\_138\_38\_20190418\_00051.jpg

LM Start	2.81	Rating **	U	Issue No.	38
LM End	3.78	Issue Type +	Ma	Location *	WS
Category	Earthen Levee			GPS Latitude/Longitude	
				Start	End
Item	Vegetation			37.244756 °	37.254845 °
				-120.707371 °	-120.719719 °
DWR ID	DWR_NA0010_22A_s_2019_38				
Comment Code					
V1 : Control annual grass and weeds on the levee slopes and easements.					
Inspector Comment

View of waterside slope looking downstream. (Spring 2019)

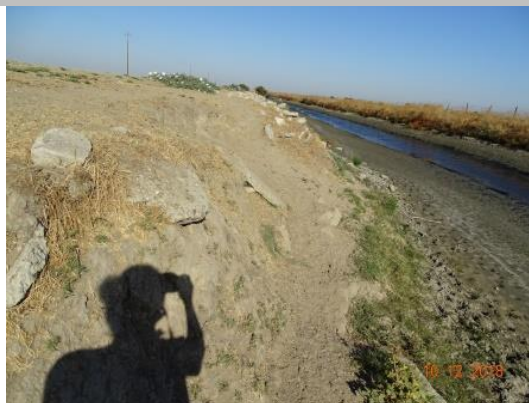
Photo 2 of 2 : SP\_2019\_NA0010\_138\_30\_20190307\_00028.jpg

View along waterside slope. (Fall 2018)

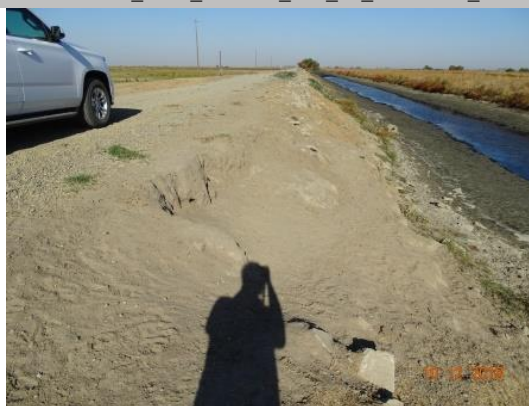
Photo 1 of 1 : SP\_2019\_NA0010\_138\_32\_20190307\_00030.jpg

LM Start	2.96	Rating **	U	Issue No.	32
LM End	2.96	Issue Type +	Ma	Location *	WS
Category	Earthen Levee			GPS Latitude/Longitude	
				Start	End
Item	Erosion / Bank Caving			37.246408 °	37.246408 °
				-120.709197 °	-120.709197 °
DWR ID	DWR_NA0010_22A_f_2018_32				
Comment Code					
E1 : Note and monitor erosion site.					
Inspector Comment					
Erosion is cutting into the waterside slope.

View of waterside slope erosion. (Fall 2018)

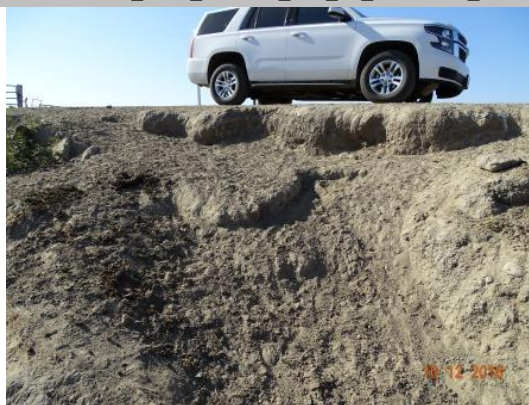
Photo 1 of 1 : SP\_2019\_NA0010\_138\_34\_20190307\_00032.jpg

LM Start	3.44	Rating **	U	Issue No.	34
LM End	3.44	Issue Type +	Ma	Location *	WS
Category	Earthen Levee			GPS Latitude/Longitude	
				Start	End
Item	Erosion / Bank Caving			37.251370 °	37.251370 °
				-120.715344 °	-120.715344 °
DWR ID	DWR_NA0010_22A_f_2018_34				
Comment Code					
E1 : Note and monitor erosion site.					
Inspector Comment					
Slope erosion is from livestock.

View of erosion on slope looking from waterside toe. (Fall 2018)

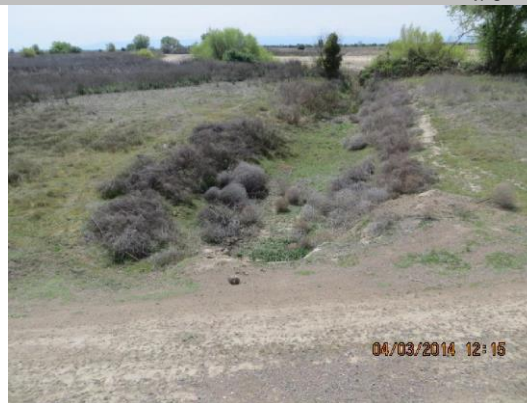
Photo 1 of 3 : UCIP\_SP\_2019\_39537\_59860.jpg

Comment Code						
Inspector Comment						
FS_ID:39537 DS_ID:19945 EP_NO: N/A Repair Type: Non-Urgent Crossing Status: Found UCIP Comments: 04/03/2014 Excessive vegetation at inlet--recommend clearing. (DWR UCIP - W. Wylie) FIELD_STRUCT_DESC: 30-inch by 30-inch square reinforced concrete box gravity drainage culvert through the levee, 13 feet below the crown. Flap gate on the waterside (WS) end. Concrete headwall on the landside (LS) end. Concrete U-shaped headwall on the WS end. (Plans to construct a new discharge structure and to rehabilitate one existing diversion structure to return intercepted seepage to the San Joaquin River authorized under Permit No. 13085, 1981 - Diener, Dry River Farms). [Additional Reference(s): DWR Levee Log, 2002. USACE San Joaquin O&M Manual 601.1, 1967, (HLM 0.21)]. FS Date: 4/3/2014

Concrete headwall on WS toe at channel.

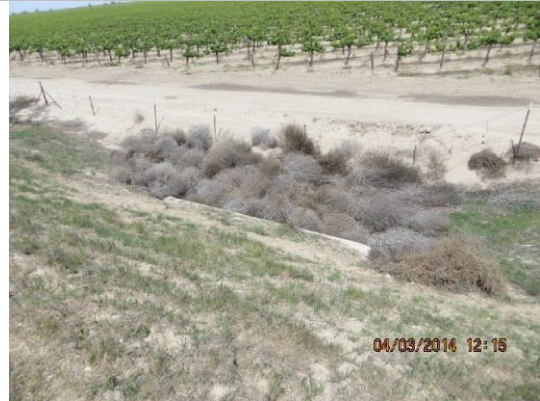
Photo 3 of 3 : UCIP\_SP\_2019\_39537\_59861.jpg

Comment Code						
Inspector Comment						
FS_ID:39537 DS_ID:19945 EP_NO: N/A Repair Type: Non-Urgent Crossing Status: Found UCIP Comments: 04/03/2014 Excessive vegetation at inlet--recommend clearing. (DWR UCIP - W. Wylie) FIELD_STRUCT_DESC: 30-inch by 30-inch square reinforced concrete box gravity drainage culvert through the levee, 13 feet below the crown. Flap gate on the waterside (WS) end. Concrete headwall on the landside (LS) end. Concrete U-shaped headwall on the WS end. (Plans to construct a new discharge structure and to rehabilitate one existing diversion structure to return intercepted seepage to the San Joaquin River authorized under Permit No. 13085, 1981 - Diener, Dry River Farms). [Additional Reference(s): DWR Levee Log, 2002. USACE San Joaquin O&M Manual 601.1, 1967, (HLM 0.21)]. FS Date: 4/3/2014

Concrete headwall at LS toe. Excess vegetation buildup at inlet.

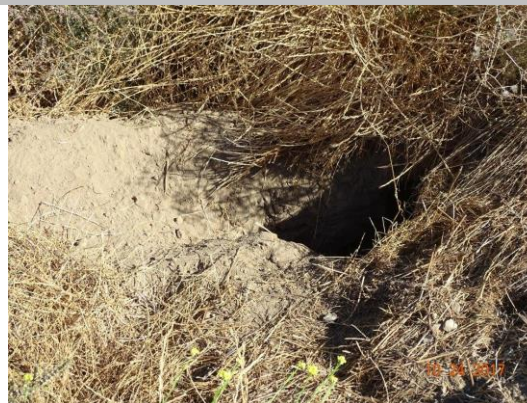
Photo 1 of 1 : SP\_2019\_NA0010\_139\_26\_20190307\_00008.jpg

LM Start	1.09	Rating **	U	Issue No.	26
LM End	1.09	Issue Type +	Ma	Location *	LS
Category	Earthen Levee			GPS Latitude/Longitude	
				Start	End
Item	Animal Control			36.772743 °	36.772743 °
				-120.266800 °	-120.266800 °
DWR ID	DWR_NA0010_23_f_2017_26				
Comment Code					
A3 : No rodents visible, but rodent burrows visible; need to backfill and compact or grout burrows.					
Inspector Comment					
Need to repair the large rodent hole on the landside slope.

Looking at the landside slope.

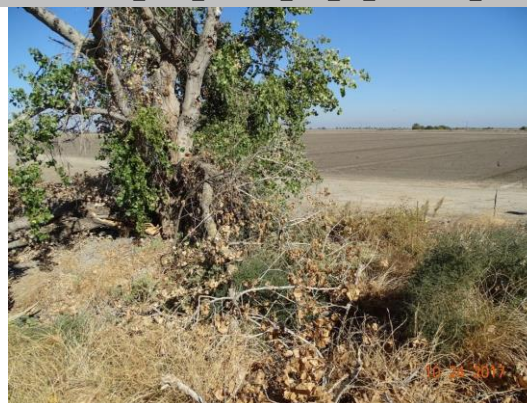
Photo 1 of 1 : SP\_2019\_NA0010\_139\_28\_20190307\_00009.jpg

LM Start	1.52	Rating **	M	Issue No.	28	
LM End	1.52	Issue Type +	Ma	Location *	LS	
Category	Earthen Levee			GPS Latitude/Longitude		
				Start		End
Item	Encroachments			36.772066 °		36.772066 °
				-120.259545 °		-120.259545 °
DWR ID	DWR_NA0010_23_f_2017_28					
Comment Code						
TR : Tree or limb						
Inspector Comment						
There are downed tree limbs on the landside slope.

Looking north at landside slope.
