**Flood Control Project Maintenance  
Levee Inspections**

## Maintenance Issue Types Only, Levee Inspection Report By Mile - Spring 2019

### Lower San Joaquin Levee District

Waterway	Bank	Unit Miles	Inspection Start/End	Inspector
Unit No. 01 San Joaquin River	Right	22.52	03/26/2019 03/26/2019	Corey Fujitani

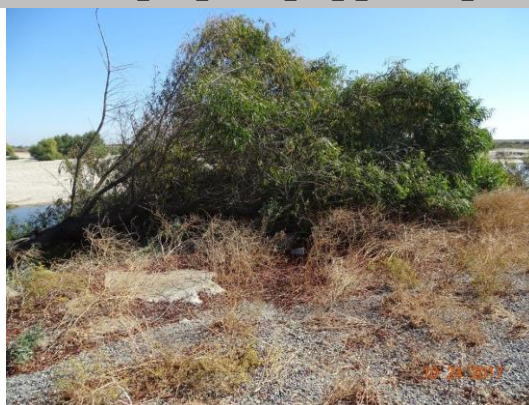
Photo 1 of 1 : SP\_2019\_NA0010\_139\_1\_20190307\_00001.jpg

LM Start	1.91	Rating **	U	Issue No.	1
LM End	1.91	Issue Type +	Ma	Location *	WS
Category	Earthen Levee			GPS Latitude/Longitude	
				Start	End
Item	Encroachments			36.772943 °	36.772943 °
				-120.253511 °	-120.253511 °
DWR ID	DWR_NA0010_23_s_2015_1				
Comment Code					
TR : Tree or limb					
Inspector Comment					
There is a downed tree on the waterside slope.

Looking east at waterside slope.

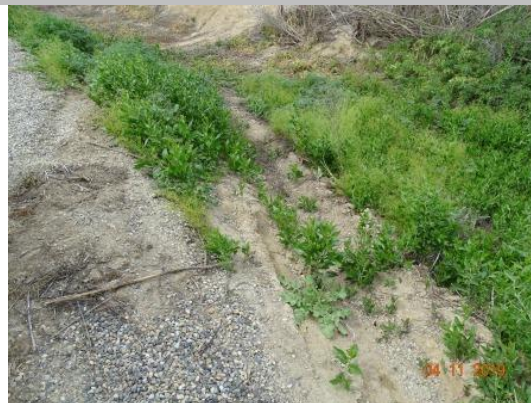
Photo 1 of 2 : SP\_2019\_NA0010\_139\_62\_20190429\_00056.jpg

LM Start	4.85	Rating **	M	Issue No.	62
LM End	4.85	Issue Type +	Ma	Location *	LS
Category	Earthen Levee			GPS Latitude/Longitude	
				Start	End
Item	Slope Stability			36.789489 °	36.789489 °
				-120.220403 °	-120.220403 °
DWR ID	DWR_NA0010_23_s_2019_62				
Comment Code					
S3 : Repair the levee slope damaged by vehicle traffic and prevent access where possible.					
Inspector Comment

View of damage to landside slope by vehicle traffic looking downstream.  
(Spring 2019)

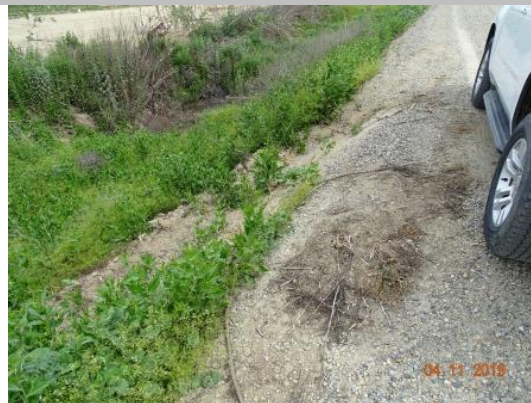
Photo 2 of 2 : SP\_2019\_NA0010\_139\_62\_20190429\_00057.jpg

LM Start	4.85	Rating **	M	Issue No.	62 (cont)	
LM End	4.85	Issue Type +	Ma	Location *	LS	
Category	Earthen Levee			GPS Latitude/Longitude		
				Start		End
Item	Slope Stability			36.789489 °		36.789489 °
				-120.220403 °		-120.220403 °
DWR ID	DWR_NA0010_23_s_2019_62					
Comment Code						
S3 : Repair the levee slope damaged by vehicle traffic and prevent access where possible.						
Inspector Comment

View of damage to slope looking upstream. (Spring 2019)

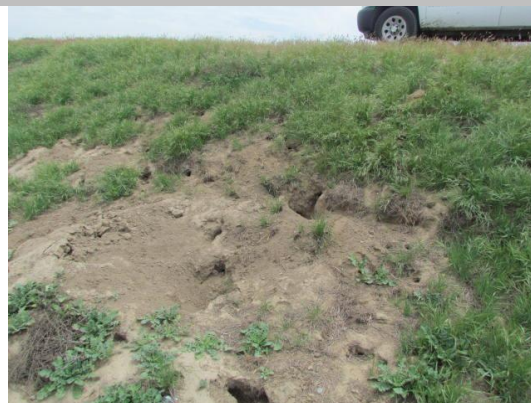
Photo 1 of 1 : SP\_2019\_NA0010\_139\_5\_20190307\_00002.jpg

LM Start	5.68	Rating **	U	Issue No.	5
LM End	5.68	Issue Type +	Ma	Location *	LS
Category	Earthen Levee			GPS Latitude/Longitude	
				Start	End
Item	Animal Control			36.791981 °	36.791981 °
				-120.206274 °	-120.206274 °
DWR ID	DWR_NA0010_23_s_2012_5				
Comment Code					
A1 : Exterminate rodents and backfill and compact or grout burrows.					
Inspector Comment					
There are several large rodent holes in this area.

Looking at several rodent holes on landside slope.

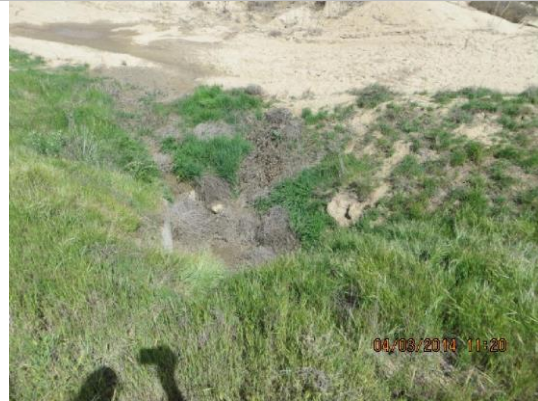
Photo 3 of 3 : UCIP\_SP\_2019\_39542\_59831.jpg

Comment Code						
Inspector Comment						
FS_ID:39542 DS_ID:19954 EP_NO: N/A Repair Type: Non-Urgent Crossing Status: Found UCIP Comments: 04/03/2014 Dense vegetation limits the inspector's visibility to identify signs of pipe failure (leaks) along the landward slope. Recommend removing vegetation along pipe alignment to conduct proper inspection of structure. (DWR UCIP - W. Wylie) FIELD_STRUCT_DESC: 36-inch by 36-inch square reinforced concrete box gravity drainage culvert through the levee, 9 feet below the crown. Flap gate on the waterside (WS) end. Concrete U-shaped headwall on each end. 5-foot-long cobble revetted outlet channel. [Additional Reference(s): DWR Levee Log, 2002. USACE San Joaquin O&M Manual 601.1, 1967, (HLM 5.71)]. FS Date: 4/3/2014

Concrete headwall at LS toe.

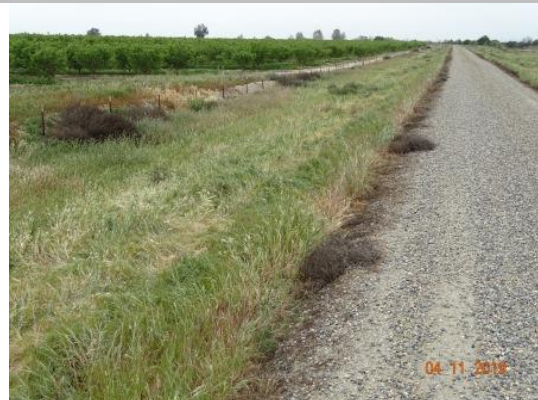
Photo 1 of 1 : SP\_2019\_NA0010\_139\_63\_20190429\_00059.jpg

LM Start	6.09	Rating **	U	Issue No.	63
LM End	9.76	Issue Type +	Ma	Location *	LS
Category	Earthen Levee			GPS Latitude/Longitude	
				Start	End
Item	Vegetation			36.788892 °	36.807942 °
				-120.200827 °	-120.168824 °
DWR ID	DWR_NA0010_23_s_2019_63				
Comment Code					
V1 : Control annual grass and weeds on the levee slopes and easements.					
Inspector Comment

View of landside slope looking upstream. (Spring 2019)

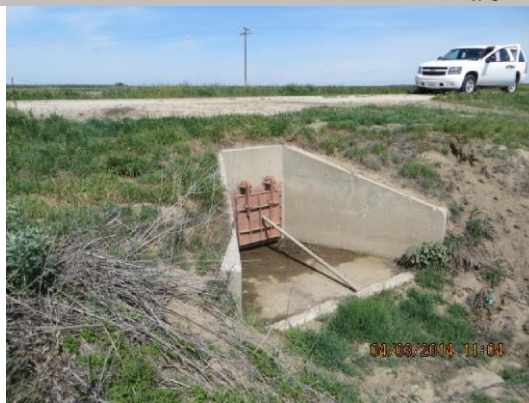
Photo 1 of 3 : UCIP\_SP\_2019\_39544\_59823.jpg

Comment Code						
Inspector Comment						
FS_ID:39544 DS_ID:19940 EP_NO: N/A Repair Type: Non-Urgent Crossing Status: Found UCIP Comments: 04/03/2014 Some sediment buildup at inlet at LS toe. Also dense vegetation limits the inspector's visibility to identify signs of pipe failure (leaks) along the landward slope. Recommend removing vegetation along pipe alignment to conduct proper inspection of structure. (DWR UCIP - W. Wylie) FIELD_STRUCT_DESC: 30-inch by 30-inch square reinforced concrete box gravity drainage culvert through the levee, 5.2 feet below the crown. Flap gate on the waterside (WS) end. Concrete headwall on the landside (LS) end. Concrete U-shaped headwall on the WS end. [Additional Reference(s): DWR Levee Log, 2002. USACE San Joaquin O&M Manual 601.1, 1967, (HLM 8.33)]. FS Date: 4/3/2014

Flapgate on WS toe.

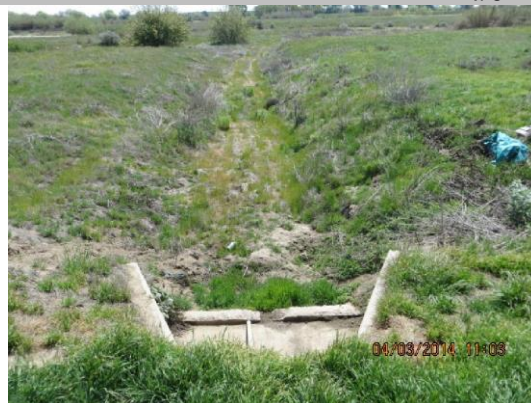
Photo 2 of 3 : UCIP\_SP\_2019\_39544\_59821.jpg

Comment Code						
Inspector Comment						
FS_ID:39544						
DS_ID:19940						
EP_NO: N/A						
Repair Type: Non-Urgent						
Crossing Status: Found						
UCIP Comments: 04/03/2014 Some sediment buildup at inlet at LS toe. Also dense vegetation limits the inspector's visibility to identify signs of pipe failure (leaks) along the landward slope. Recommend removing vegetation along pipe alignment to conduct proper inspection of structure. (DWR UCIP - W. Wylie)						
FIELD_STRUCT_DESC: 30-inch by 30-inch square reinforced concrete box gravity drainage culvert through the levee, 5.2 feet below the crown. Flap gate on the waterside (WS) end. Concrete headwall on the landside (LS) end. Concrete U-shaped headwall on the WS end.						
[Additional Reference(s): DWR Levee Log, 2002. USACE San Joaquin O&M Manual 601.1, 1967, (HLM 8.33)].						
FS Date: 4/3/2014

concrete headwall at drainage ditch on WS toe.

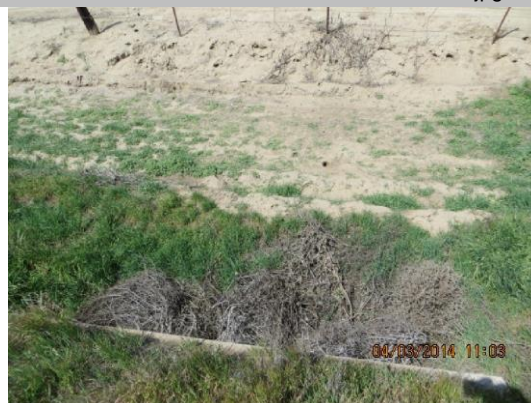
Photo 3 of 3 : UCIP\_SP\_2019\_39544\_59822.jpg

Concrete headwall on LS toe.

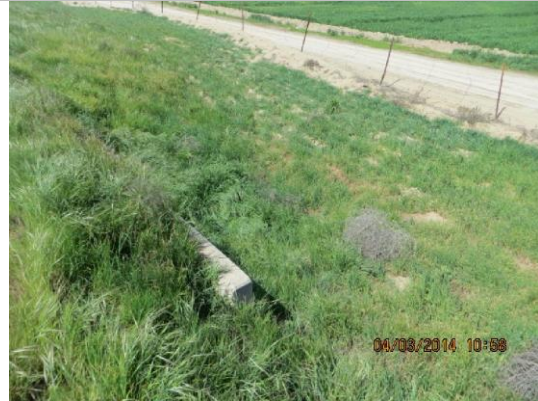
Photo 3 of 3 : UCIP\_SP\_2019\_39545\_59818.jpg

Comment Code						
Inspector Comment						
FS_ID:39545						
DS_ID:19941						
EP_NO: N/A						
Repair Type: Non-Urgent						
Crossing Status: Found						
UCIP Comments: 04/03/2014 Dense vegetation limits the inspector's visibility to identify signs of pipe failure (leaks) along the landward slope. Recommend removing vegetation along pipe alignment to conduct proper inspection of structure. (DWR UCIP - W. Wylie)						
FIELD_STRUCT_DESC: 30-inch by 30-inch square reinforced concrete box gravity drainage culvert through the levee, 5.6 feet below the crown. Flap gate on the waterside (WS) end. Concrete headwall on the landside (LS) end. Concrete U-shaped headwall on the WS end.						
[Additional Reference(s): DWR Levee Log, 2002. USACE San Joaquin O&M Manual 601.1, 1967, (HLM 8.54)].						
FS Date: 4/3/2014

Concrete headwall on LS toe.

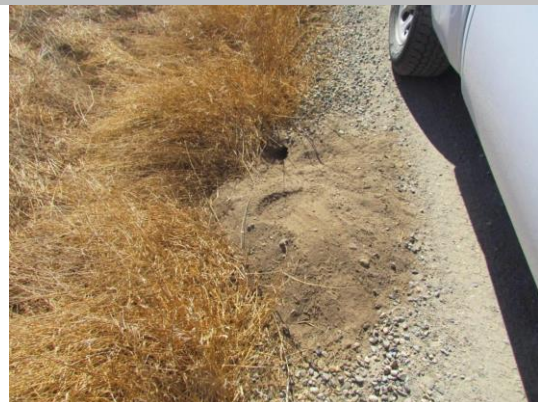
Photo 1 of 1 : SP\_2019\_NA0010\_139\_25\_20190307\_00007.jpg

LM Start	8.97	Rating **	M	Issue No.	25
LM End	8.97	Issue Type +	Ma	Location *	WS
Category	Earthen Levee			GPS Latitude/Longitude	
				Start	End
Item	Animal Control			36.799606 °	36.799606 °
				-120.175395 °	-120.175395 °
DWR ID	DWR_NA0010_23_f_2016_25				
Comment Code					
A3 : No rodents visible, but rodent burrows visible; need to backfill and compact or grout burrows.					
Inspector Comment					
There are rodent holes on the waterside shoulder.

Looking at typical view of rodent hole on waterward shoulder.

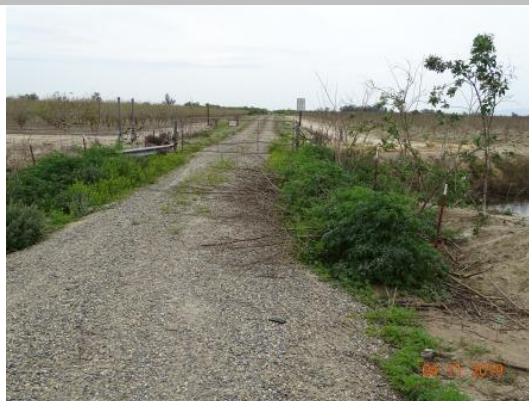
Photo 1 of 3 : SP\_2019\_NA0010\_139\_58\_20190429\_00060.jpg

LM Start	9.79	Rating **	M	Issue No.	58
LM End	9.81	Issue Type +	Ma	Location *	LS
Category	Earthen Levee			GPS Latitude/Longitude	
				Start	End
Item	Trim / Thin Trees			36.808317 °	36.808553 °
				-120.168820 °	-120.168827 °
DWR ID	DWR_NA0010_23_f_2018_58				
Comment Code					
T2 : Thin trees to allow visibility of the ground and room to flood fight.					
Inspector Comment					
Woody vegetation is partially blocking crown and landside slope.

View of woody vegetation on landside shoulder partially blocking access across crown. (Spring 2019)

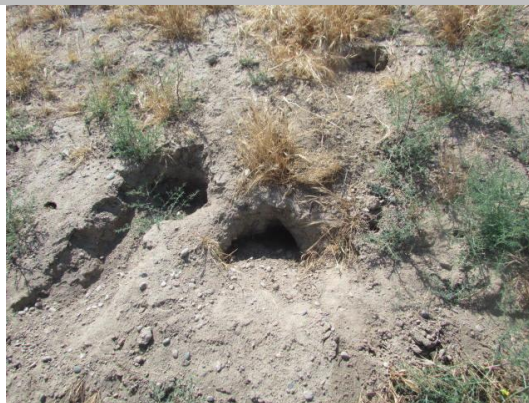
Photo 1 of 1 : SP\_2019\_NA0010\_140\_6\_20190307\_00002.jpg

LM Start	0.82	Rating **	M	Issue No.	6
LM End	0.84	Issue Type +	Ma	Location *	LS
Category	Earthen Levee			GPS Latitude/Longitude	
				Start	End
Item	Animal Control			36.766775 °	36.766962 °
				-120.278757 °	-120.278602 °
DWR ID	DWR_NA0010_24_s_2013_6				
Comment Code					
A1 : Exterminate rodents and backfill and compact or grout burrows.					
Inspector Comment					
There are several rodent holes identified within this section.

Looking at several rodent holes on landward slope.

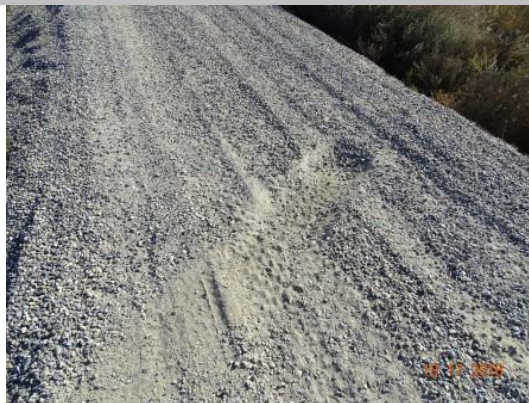
Photo 1 of 1 : SP\_2019\_NA0010\_140\_30\_20190307\_00012.jpg

LM Start	2.52	Rating **	A/W	Issue No.	30
LM End	2.52	Issue Type +	Ma	Location *	CR
Category	Earthen Levee			GPS Latitude/Longitude	
				Start	End
Item	Crown Surface / Depressions / Rutting			36.770298 °	36.770298 °
				-120.253468 °	-120.253468 °
DWR ID	DWR_NA0010_24_f_2018_30				
Comment Code					
C2 : Repair depressions or ruts in the crown or slope.					
Inspector Comment					
There is a depression across the crown of the levee.

View of depression across crown. (Fall 2018)

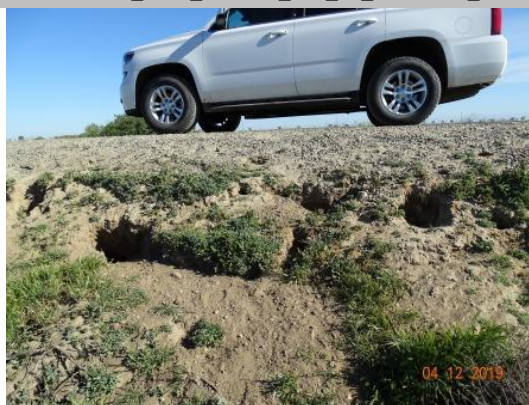
Photo 1 of 1 : SP\_2019\_NA0010\_140\_51\_20190429\_00046.jpg

LM Start	3.05	Rating **	U	Issue No.	51
LM End	3.10	Issue Type +	Ma	Location *	LS
Category	Earthen Levee			GPS Latitude/Longitude	
				Start	End
Item	Animal Control			36.770146 °	36.769966 °
				-120.245703 °	-120.244853 °
DWR ID	DWR_NA0010_24_s_2019_51				
Comment Code					
A3 : No rodents visible, but rodent burrows visible; need to backfill and compact or grout burrows.					
Inspector Comment

View of rodent holes in landside slope. (Spring 2019)

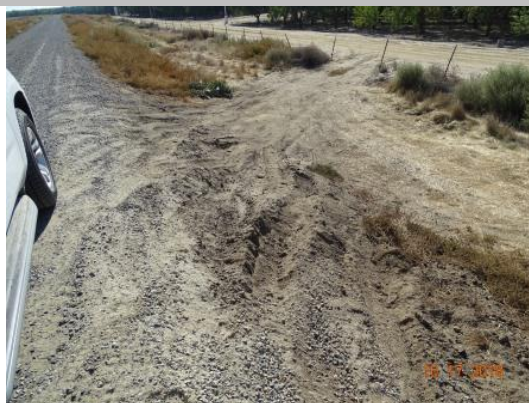
Photo 1 of 1 : SP\_2019\_NA0010\_140\_35\_20190307\_00015.jpg

LM Start	3.53	Rating **	M	Issue No.	35
LM End	3.53	Issue Type +	Ma	Location *	LS
Category	Earthen Levee			GPS Latitude/Longitude	
				Start	End
Item	Slope Stability			36.768873 °	36.768873 °
				-120.237161 °	-120.237161 °
DWR ID	DWR_NA0010_24_f_2018_35				
Comment Code					
S3 : Repair the levee slope damaged by vehicle traffic and prevent access where possible.					
Inspector Comment					
There is vehicle damage to the landside slope. The land owner removed a section of the fence to allow access at this location.

View of damage to slope from vehicle traffic. (Fall 2018)

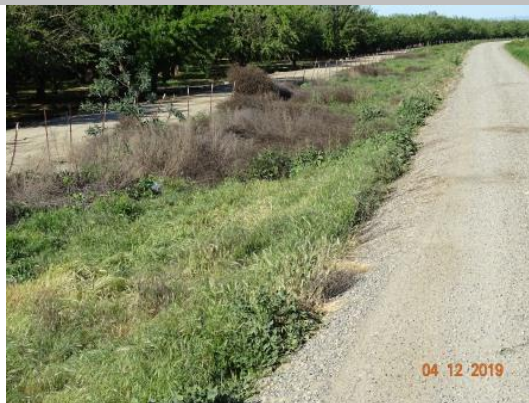
Photo 1 of 1 : SP\_2019\_NA0010\_140\_49\_20190429\_00048.jpg

LM Start	3.76	Rating **	U	Issue No.	49
LM End	5.38	Issue Type +	Ma	Location *	LS
Category	Earthen Levee			GPS Latitude/Longitude	
				Start	End
Item	Vegetation			36.767767 °	36.782291 °
				-120.233436 °	-120.223202 °
DWR ID	DWR_NA0010_24_s_2019_49				
Comment Code					
V1 : Control annual grass and weeds on the levee slopes and easements.					
Inspector Comment

View of landside slope looking downstream. (Spring 2019)

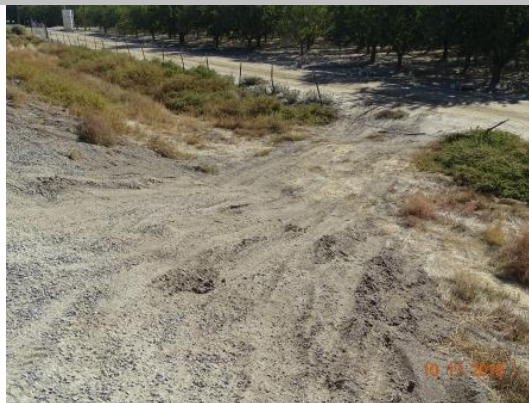
Photo 1 of 1 : SP\_2019\_NA0010\_140\_36\_20190307\_00016.jpg

LM Start	3.77	Rating **	M	Issue No.	36
LM End	3.77	Issue Type +	Ma	Location *	LS
Category	Earthen Levee			GPS Latitude/Longitude	
				Start	End
Item	Slope Stability			36.767784 °	36.767784 °
				-120.233252 °	-120.233252 °
DWR ID	DWR_NA0010_24_f_2018_36				
Comment Code					
S3 : Repair the levee slope damaged by vehicle traffic and prevent access where possible.					
Inspector Comment					
There is damage to the levee slope from vehicle traffic. The landowner appears to have removed a section of fencing to allow access at this location.

View of damage to slope from vehicle traffic. (Fall 2018)

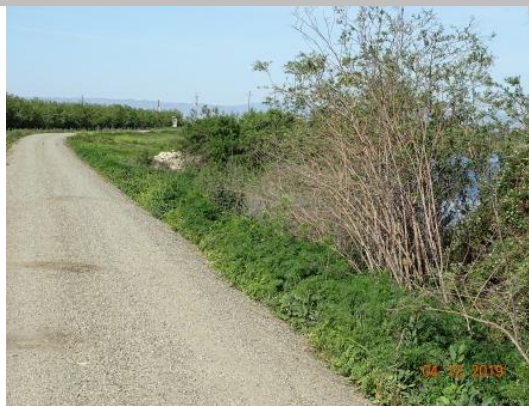
Photo 1 of 1 : SP\_2019\_NA0010\_140\_24\_20190429\_00050.jpg

LM Start	4.08	Rating **	U	Issue No.	24
LM End	7.33	Issue Type +	Ma	Location *	WS
Category	Earthen Levee			GPS Latitude/Longitude	
				Start	End
Item	Vegetation			36.769539 °	36.779339 °
				-120.228514 °	-120.199032 °
DWR ID	DWR_NA0010_24_s_2019_24				
Comment Code					
V1 : Control annual grass and weeds on the levee slopes and easements.					
Inspector Comment

View of waterside slope looking downstream. (Spring 2019)

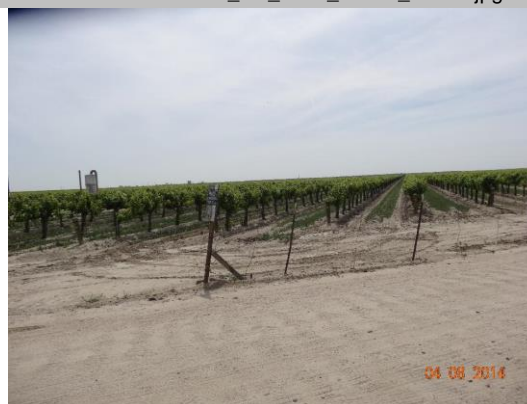
Photo 2 of 2 : UCIP\_SP\_2019\_33272\_60120.jpg

View of landward side.

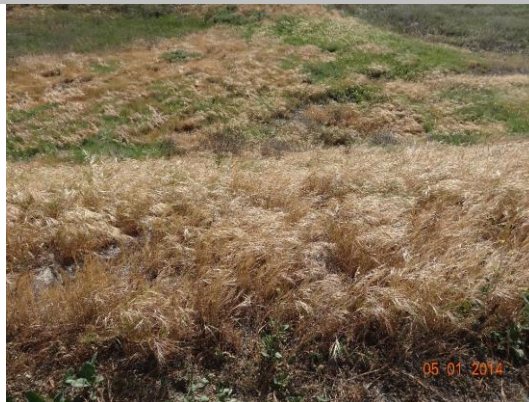
Photo 3 of 3 : UCIP\_SP\_2019\_39501\_67241.jpg

View of landward side--dense vegetation on landward side.

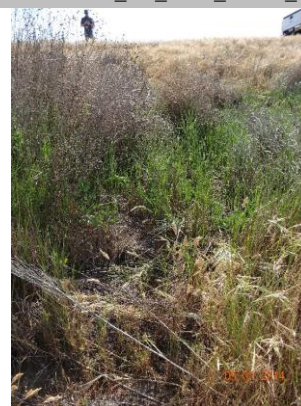
Photo 2 of 3 : UCIP\_SP\_2019\_36852\_67251.jpg

Comment Code						
Inspector Comment						
FS_ID:36852 DS_ID:19967 EP_NO: N/A Repair Type: Non-Urgent Crossing Status: Found UCIP Comments: 05/01/2014 Dense vegetation limits the inspectors visibility to identify signs of pipe failure (leaks) along the slope. Recommend removing vegetation along pipe alignment to conduct proper inspection of structure. (DWR UCIP - O. Magana) FIELD_STRUCT_DESC: 24-inch corrugated metal gravity drainage pipe through the levee, 14.7 feet below the crown. Flap gate on the waterside (WS) end. [Additional Reference(s): DWR Levee Log, 2002. USACE San Joaquin O&M Manual 601.1, 1967, (HLM 0.59)]. FS Date: 5/1/2014

View of waterward slope covered by dense vegetation.

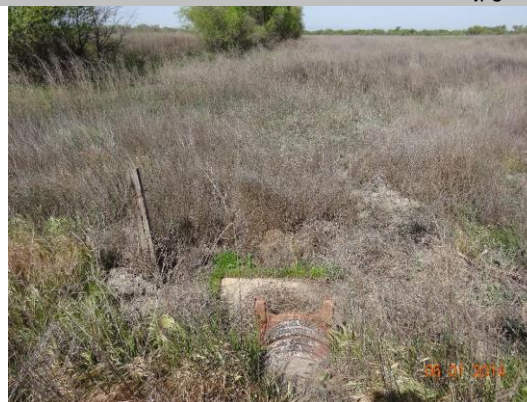
Photo 3 of 3 : UCIP\_SP\_2019\_36852\_67252.jpg

Pipe and flap gate visible on waterward side.

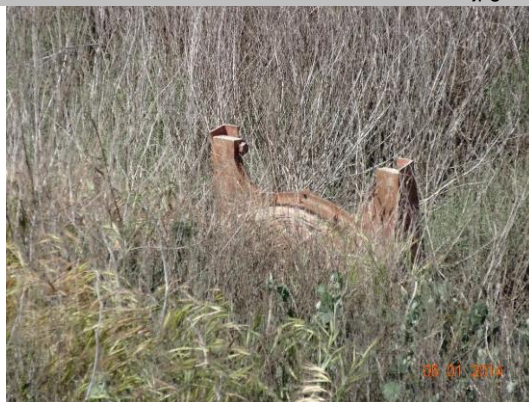
Photo 2 of 3 : UCIP\_SP\_2019\_36853\_67255.jpg

Pipe and evidence of flap gate visible on waterward side.

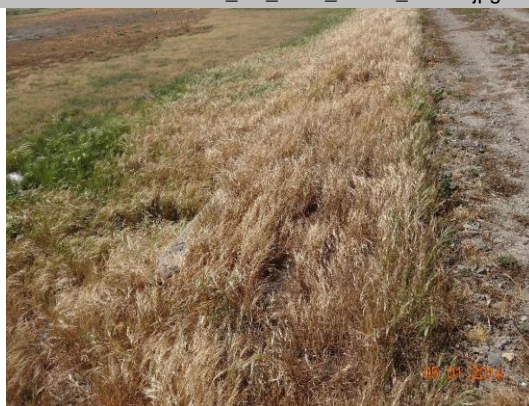
Photo 1 of 3 : UCIP\_SP\_2019\_36854\_67259.jpg

LM Start	2.05	Rating **	M	Issue No.	18
LM End	2.05	Issue Type +	Ma	Location *	
Category	Supplemental			GPS Latitude/Longitude	
				Start	End
Item	DWR UCIP LMA Responsibility			37.277390 °	37.277390 °
				-120.867184 °	-120.867184 °
DWR ID	19969				
Comment Code					
Inspector Comment					
FS_ID:36854 DS_ID:19969 EP_NO: N/A Repair Type: Non-Urgent Crossing Status: Found UCIP Comments: 05/01/2014 Dense vegetation limits the inspectors visibility to identify signs of pipe failure (leaks) along the slope. Recommend removing vegetation along pipe alignment to conduct proper inspection of structure. (DWR UCIP - O. Magana) FIELD_STRUCT_DESC: 24-inch corrugated metal gravity drainage pipe through the levee, 4 feet below the crown. Flap gate on the waterside (WS) end. [Additional Reference(s): DWR Levee Log, 2002. USACE San Joaquin O&M Manual 601.1, 1967, (HLM 2.05)]. FS Date: 5/1/2014

View of landward side.

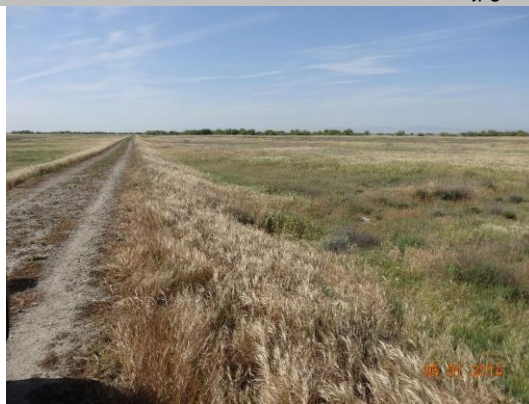
Photo 2 of 3 : UCIP\_SP\_2019\_36854\_67260.jpg

View of waterward side.

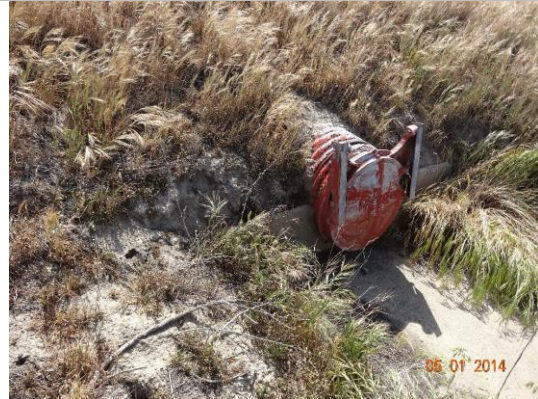
Photo 3 of 3 : UCIP\_SP\_2019\_36854\_67261.jpg

Comment Code					
Inspector Comment					
FS_ID:36854 DS_ID:19969 EP_NO: N/A Repair Type: Non-Urgent Crossing Status: Found UCIP Comments: 05/01/2014 Dense vegetation limits the inspectors visibility to identify signs of pipe failure (leaks) along the slope. Recommend removing vegetation along pipe alignment to conduct proper inspection of structure. (DWR UCIP - O. Magana) FIELD_STRUCT_DESC: 24-inch corrugated metal gravity drainage pipe through the levee, 4 feet below the crown. Flap gate on the waterside (WS) end. [Additional Reference(s): DWR Levee Log, 2002. USACE San Joaquin O&M Manual 601.1, 1967, (HLM 2.05)]. FS Date: 5/1/2014

Flap gate and concrete headwall located on waterward toe.

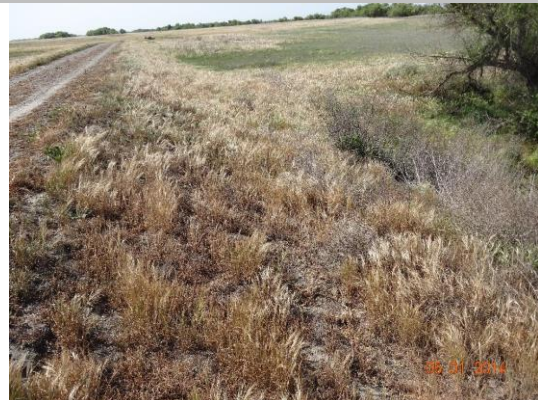
Photo 1 of 3 : UCIP\_SP\_2019\_39502\_67270.jpg

Comment Code						
Inspector Comment						
FS_ID:39502 DS_ID:19970 EP_NO: N/A Repair Type: Non-Urgent Crossing Status: Found UCIP Comments: 05/01/2014 Dense vegetation limits the inspectors visibility to identify signs of pipe failure (leaks) along the slope. Recommend removing vegetation along pipe alignment to conduct proper inspection of structure. Sediment buildup in pipe visible on landward side--recommend clearing. (DWR UCIP - O. Magana) FIELD_STRUCT_DESC: 24-inch corrugated metal gravity drainage pipe through the levee, 11.2 feet below the crown. Flap gate on the waterside (WS) end. [Additional Reference(s): DWR Levee Log, 2002. USACE San Joaquin O&M Manual 601.1, 1967, (HLM 2.45)]. FS Date: 5/1/2014 4:04:00 PM

View of waterward side.

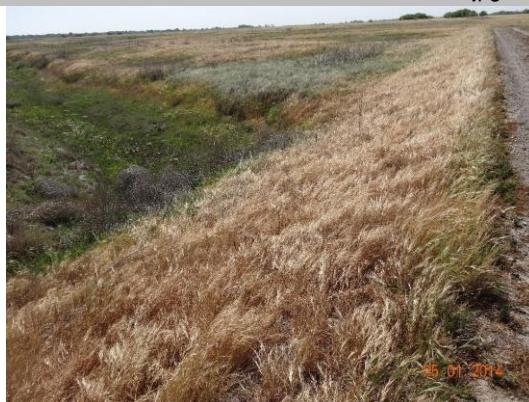
Photo 3 of 3 : UCIP\_SP\_2019\_39502\_67268.jpg

View of landward side.
