**Flood Control Project Maintenance  
Levee Inspections**

## Maintenance Issue Types Only, Levee Inspection Report By Mile - Spring 2021

### Lower San Joaquin Levee District

Waterway	Bank	Unit Miles	Inspection Start/End	Inspector
Unit No. 01 San Joaquin River	Right	22.52	05/04/2021 05/04/2021	Corey Fujitani

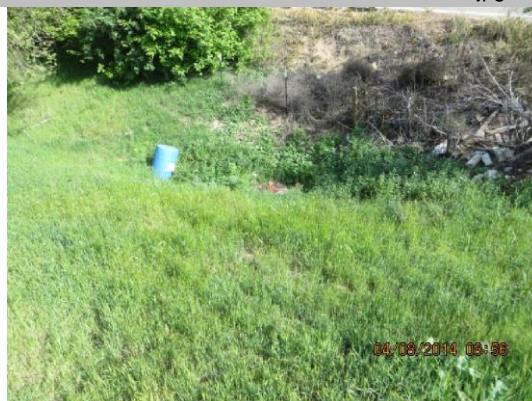
Photo 1 of 3 : UCIP\_SP\_2021\_62752\_60601.jpg

FS\_ID:62752  
DS\_ID:19650  
EP\_NO: N/A  
Repair Type: Urgent  
Crossing Status: Found  
UCIP Comments: 10/06/2020 Pipe status is still Urgent. DWR DMP has found integrity issues, LOF between 4 and 5. Crossing will be monitored until funding becomes available for rehabilitation. Dense vegetation was found along the LS and WS. No permit was found for this crossing. No permit was found authorizing this encroachment. CVFPB will need to review crossing to determine owner. (B. Singh - GEI, O. Magana - DWR UCIP)04/08/2014 Dense vegetation limits the inspector's visibility to identify signs of pipe failure (leaks) along the waterward slope and landward toe. Recommend removing vegetation along pipe alignment and landward toe to conduct proper inspection of structure and appurtenances. (W. Wylie - DWR UCIP)  
FIELD\_STRUCT\_DESC: 24-inch corrugated metal gravity drainage pipe through the levee, 10.5 feet below the crown. Flap gate on the waterside (WS) end. Brass cap No. 108 bench mark (BM) on the headwall on the landside (LS), elevation 65.1 feet, USGS Datum.

Flapgate on WS toe.

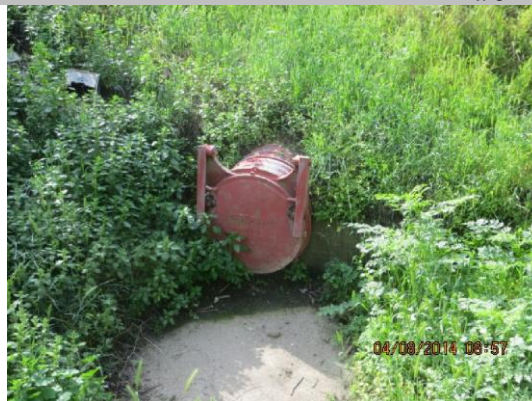
Photo 2 of 3 : UCIP\_SP\_2021\_62752\_60600.jpg

Flapgate on WS toe.

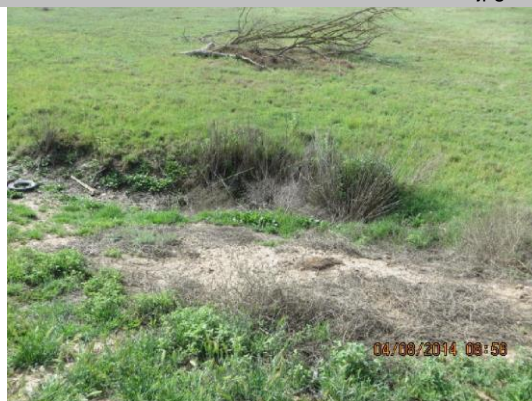
Photo 3 of 3 : UCIP\_SP\_2021\_62752\_60602.jpg

LM Start	<b>0.00</b>	Rating **	U	Issue No.	<b>1 (cont)</b>
LM End	<b>0.00</b>	Issue Type +	Ma	Location *	
Category	Supplemental		GPS Latitude/Longitude		
			Start	End	
Item	DWR UCIP LMA Responsibility		37.348637 °	37.348637 °	
			-120.958834 °	-120.958834 °	
DWR ID	19650

Headwall on LS toe.

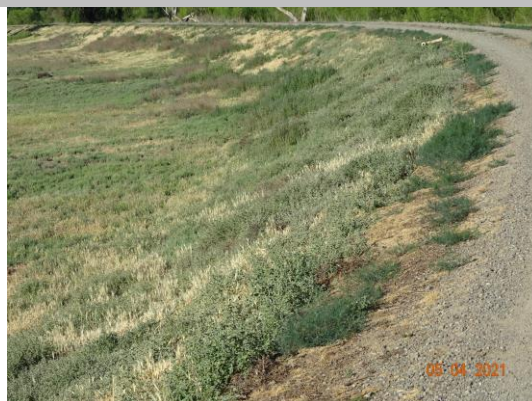
Photo 1 of 1 : SP\_2021\_NA0010\_118\_96\_20210517\_00301.jpg

LM Start	0.01	Rating **	M	Issue No.	96
LM End	0.14	Issue Type +	Ma	Location *	LS
Category	Earthen Levee			GPS Latitude/Longitude	
				Start	End
Item	Vegetation			37.348629 °	37.347253 °
				-120.958901 °	-120.960480 °
DWR ID	DWR_NA0010_01_s_2021_96				
Comment Code					
V1 : Control annual grass and weeds on the levee slopes and easements.					
Inspector Comment

View of the landside slope looking upstream. (Spring 2021)

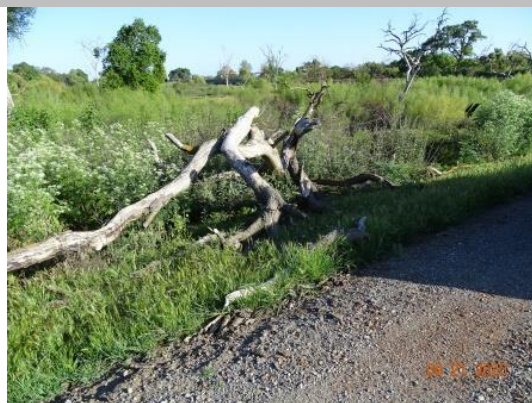
Photo 1 of 1 : SP\_2021\_NA0010\_118\_143\_20210308\_00029.jpg

LM Start	0.12	Rating **	M	Issue No.	143
LM End	0.12	Issue Type +	Ma	Location *	WS
Category	Earthen Levee			GPS Latitude/Longitude	
				Start	End
Item	Encroachments			37.347444 °	37.347444 °
				-120.960311 °	-120.960311 °
DWR ID	DWR_NA0010_01_s_2020_143				
Comment Code					
TR : Tree or limb					
Inspector Comment

Downed tree limb should be removed from the waterside shoulder. (Spring 2020)

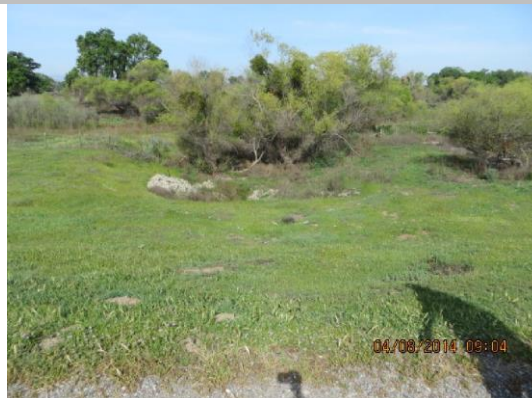
Photo 1 of 3 : UCIP\_SP\_2021\_62609\_60611.jpg

Comment Code						
Inspector Comment						
FS_ID:62609 DS_ID:19651 EP_NO: N/A Repair Type: Non-Urgent Crossing Status: Found UCIP Comments: 10/06/2020 Pipe status is still Non-Urgent. No permit was found authorizing this encroachment. Recommend maintenance to clear up sediment buildup through the pipe. CVFPB will need to review crossing to determine owner. DWR DMP has not completed an internal inspection of the pipe, but is scheduled for 2021. (B. Singh - GEI, O. Magana - DWR UCIP)04/08/2014 Pipe has significant sediment buildup and shows some signs of corrosion at landward toe. Recommend cleaning sediment from inside pipe and check wall integrity. (W. Wylie - DWR UCIP) FIELD_STRUCT_DESC: 36-inch corrugated metal gravity drainage pipe through the levee, 18.5 feet below the crown. Flap gate on the waterside (WS) end. Brass cap No. 108 bench mark (BM) on the headwall on the landside (LS). [Additional Reference(s): DWR Levee Log, 2002 (HLM 0.35), listed as 36-inch corrugated metal pipe (CMP). USACE San Joaquin O&M Manual, Unit 601 Part 1 (SJR601.1), 1967, Revised 25 May 2011, (HLM 0.35), listed as a 36-inch CMP]. FS Date: 10/6/2020

Flapgate and headwall visible off WS toe.

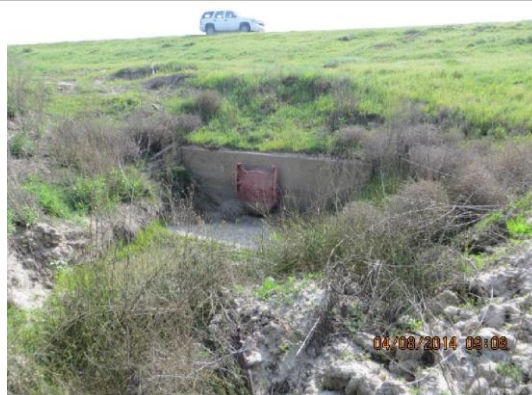
Photo 2 of 3 : UCIP\_SP\_2021\_62609\_60613.jpg

Flapgate and headwall visible off WS toe.

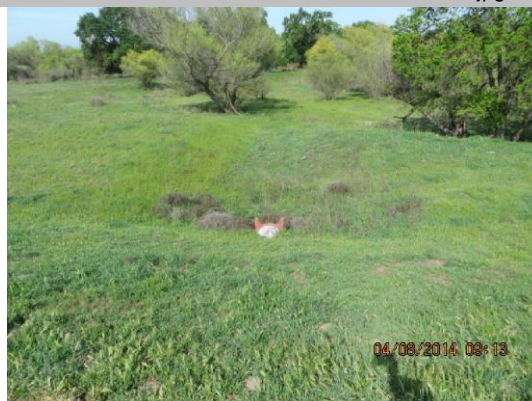
Photo 1 of 3 : UCIP\_SP\_2021\_62645\_60622.jpg

Comment Code						
Inspector Comment						
FS_ID:62645 DS_ID:19583 EP_NO: N/A Repair Type: Non-Urgent Crossing Status: Found UCIP Comments: 10/06/2020 Pipe status is still Non-Urgent. No permit was found authorizing this encroachment. Rodent activity; recommend mitigation. CVFPB will need to review crossing to determine owner. DWR DMP has not found internal issues, LOF between 1 and 2. Recommend inspection in 5 years. (B. Singh - GEI, O. Magana - DWR UCIP)04/08/2014 Recommend removing vegetation pile from waterward toe. (W. Wylie - DWR UCIP) FIELD_STRUCT_DESC: 24-inch corrugated metal gravity drainage pipe through the levee, 8.5 feet below the crown. Flap gate on the waterside (WS) end. Brass cap No. 108 bench mark (BM) on the headwall on the landside (LS). [Additional Reference(s): DWR Levee Log, 2002 (HLM 0.62), listed as a 24-inch corrugated metal pipe (CMP). USACE San Joaquin O&M Manual, Unit 601 Part 1 (SJR601.1), 1967, Revised 25 May 2011, (HLM 0.62), listed as a 24-inch CMP]. FS Date: 10/6/2020

Flapgate and headwall visible on WS toe.

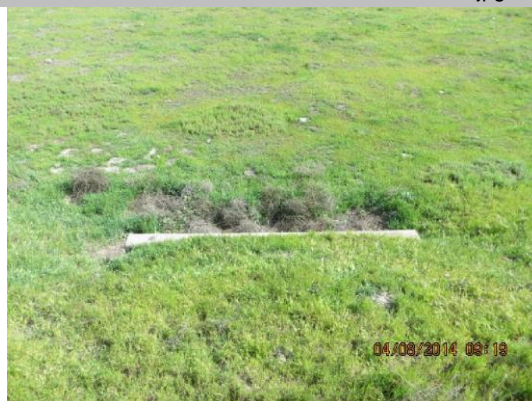
Photo 2 of 3 : UCIP\_SP\_2021\_62646\_60626.jpg

Pipe and headwall visible on LS toe.

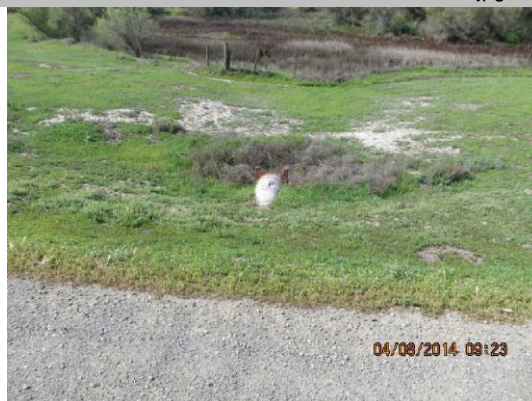
Photo 1 of 3 : UCIP\_SP\_2021\_62648\_60632.jpg

Comment Code						
Inspector Comment						
FS_ID:62648 DS_ID:19585 EP_NO: N/A Repair Type: Urgent Crossing Status: Found UCIP Comments: 10/06/2020 Pipe status is still Urgent. DWR DMP has found integrity issues, likelihood of failure between 5 and 6. Scour visible near LS toe surrounding headwall. Crossing will be monitored until funding becomes available for removal. No permit was found authorizing this encroachment. CVFPB will need to review crossing to determine owner. (B. Singh - GEI, O. Magana - DWR UCIP)04/08/2014 Moderate erosion around headwall on landward toe. May or may not be an issue. Need to contact owner to determine status of crossing and to address erosion issue on landward side. (W. Wylie - DWR UCIP) FIELD_STRUCT_DESC: 24-inch corrugated metal gravity drainage pipe through the levee, 9 feet below the crown. Flap gate on the waterside (WS) end. Brass cap No. 108 bench mark (BM) on the headwall on the landside (LS). [Additional Reference(s): DWR Levee Log, 2002 (HLM 0.96), listed as a 24-inch corrugated metal pipe (CMP). USACE San Joaquin O&M Manual, Unit 601 Part 1 (SJR601.1), 1967, Revised 25 May 2011, (HLM 0.95), listed as a 24-inch CMP]. FS Date: 10/6/2020

Flapgate, pipe, and headwall on WS toe.

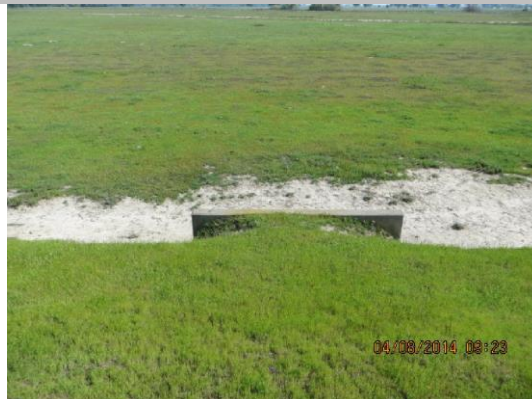
Photo 2 of 3 : UCIP\_SP\_2021\_62648\_60631.jpg

Concrete headwall and pipe visible at LS toe.

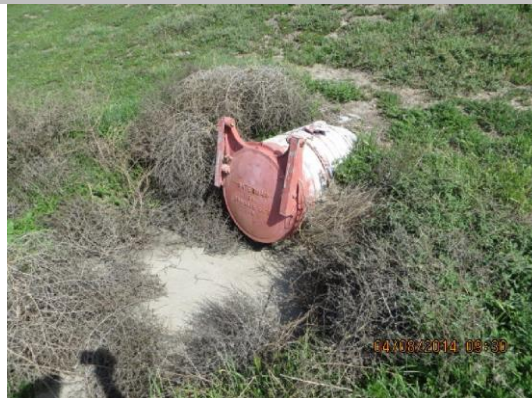
Photo 2 of 3 : UCIP\_SP\_2021\_62615\_60643.jpg

Pipe, headwall, and flapgate visible on WS toe.

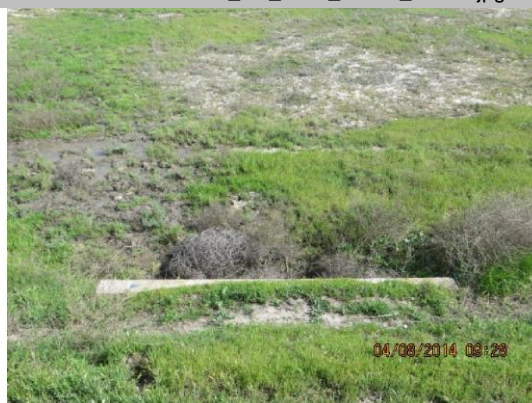
Photo 3 of 3 : UCIP\_SP\_2021\_62615\_60641.jpg

Headwall and pipe visible on LS toe.

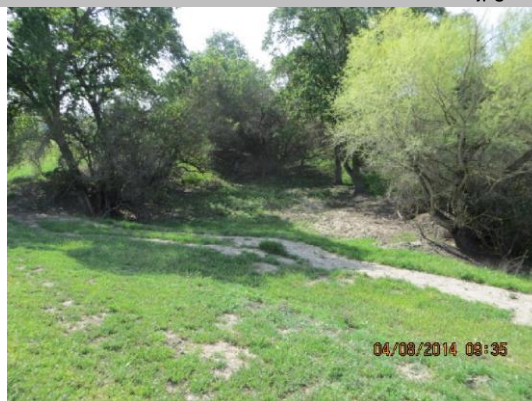
Photo 1 of 3 : UCIP\_SP\_2021\_62617\_60649.jpg

Comment Code						
Inspector Comment						
FS_ID:62617 DS_ID:19587 EP_NO: N/A Repair Type: Non-Urgent Crossing Status: Found UCIP Comments: 10/06/2020 Pipe status is still Non-Urgent. No permit was found authorizing this encroachment. CVFPB will need to review crossing to determine owner. DWR DMP has not completed an internal inspection of the pipe but it is scheduled for 2021. (B. Singh - GEI, O. Magana - DWR UCIP) FIELD_STRUCT_DESC: 36-inch corrugated metal gravity drainage pipe through the levee, 12.8 feet below the crown. Flap gate on the waterside (WS) end. Brass cap No. 108 bench mark (BM) on the headwall on the landside (LS). Pipe crosses through the levee at about a 45 degree angle to the crown. [Additional Reference(s): DWR Levee Log, 2002 (HLM 1.35), listed as a 36-inch corrugated metal pipe. USACE San Joaquin O&M Manual, Unit 601 Part 1 (SJR601.1), 1967, Revised 25 May 2011, (HLM 1.34), listed as a 36-inch CMP]. FS Date: 10/6/2020

Concrete headwall and flapgate visible at WS toe.

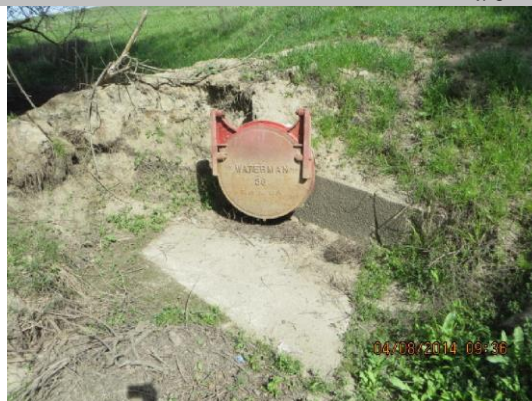
Photo 2 of 3 : UCIP\_SP\_2021\_62617\_60648.jpg

Concrete headwall and flapgate visible at WS toe.

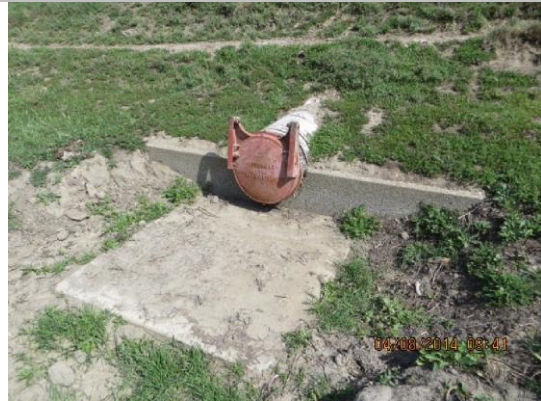
Photo 2 of 3 : UCIP\_SP\_2021\_62618\_60653.jpg

Pipe, flapgate, and concrete headwall visible on WS toe.

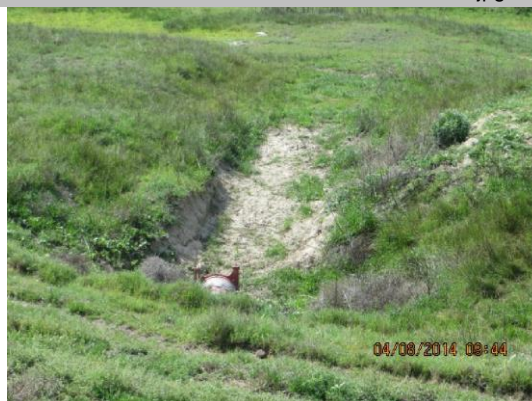
Photo 1 of 3 : UCIP\_SP\_2021\_62649\_60661.jpg

Comment Code						
Inspector Comment						
FS_ID:62649						
DS_ID:19589						
EP_NO: N/A						
Repair Type: Urgent						
Crossing Status: Found						
UCIP Comments: 10/06/2020 Pipe status is Urgent. DWR DMP has found integrity issues, LOF between 4 and 5. Crossing will be monitored until funding becomes available for rehabilitation. No permit was found authorizing this encroachment. CVFPB will need to review crossing to determine owner. Dense vegetation; recommend vegetation removal along pipe alignment (B. Singh - GEI, O. Magana - DWR UCIP)04/08/2014 Heavy sediment buildup in pipe at LS toe. (DWR UCIP - W. Wylie)						
FIELD_STRUCT_DESC: 24-inch corrugated metal gravity drainage pipe through the levee, 13.6 feet below the crown. Flap gate on the waterside (WS) end. Brass cap No. 108 bench mark (BM) on the headwall on the landside (LS). [Additional Reference(s): DWR Levee Log, 2002 (HLM 1.70), listed as a 24-inch corrugated metal pipe (CMP). USACE San Joaquin O&M Manual, Unit 601 Part 1 (SJR601.1), 1967, Revised 25 May 2011, (HLM 1.69), listed as a 24-inch CMP].

Pipe, headwall, and flapgate visible on WS toe.

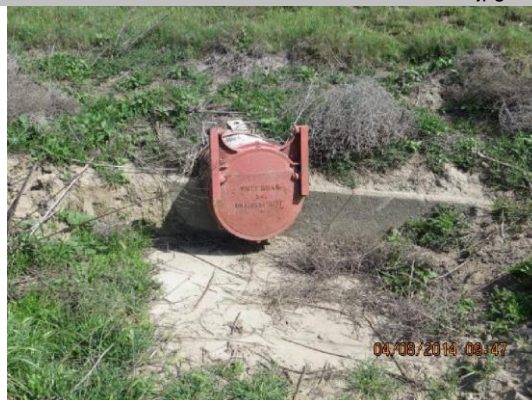
Photo 2 of 3 : UCIP\_SP\_2021\_62649\_60663.jpg

Pipe, headwall, and flapgate visible on WS toe.

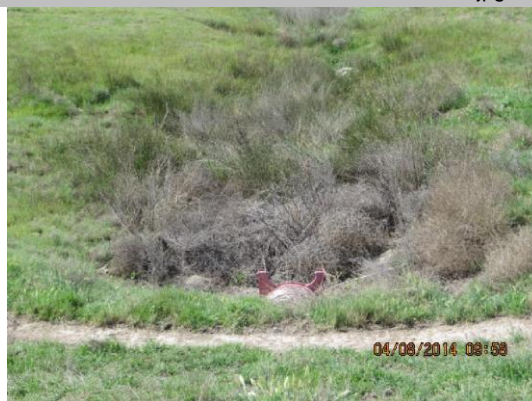
Photo 1 of 3 : UCIP\_SP\_2021\_62622\_60670.jpg

Comment Code						
Inspector Comment						
FS_ID:62622 DS_ID:19591 EP_NO: N/A Repair Type: Non-Urgent Crossing Status: Found UCIP Comments: 10/06/2020 Pipe status is still Non-Urgent. No permit was found authorizing this encroachment. CVFPB will need to review crossing to determine owner. DWR DMP has not found internal issues, LOF between 1 and 2. Rodent activity, recommend mitigation. Recommend inspection in 5 years. (B. Singh - GEI, O. Magana - DWR UCIP)04/08/2014 Need to contact owner to determine crossing status. Inlet drop box silted in and needs to be cleaned out. (W. Wylie - DWR UCIP) FIELD_STRUCT_DESC: 24-inch corrugated metal gravity drainage pipe through the levee, 9.7 feet below the crown. Flap gate on the waterside (WS) end. Brass cap No. 100 bench mark (BM) on the headwall on the landside (LS). Wooden barrier around drop inlet on the LS toe. [Additional Reference(s): DWR Levee Log, 2002 (HLM 1.98), listed as a 24-inch corrugated metal pipe (CMP). USACE San Joaquin O&M Manual, Unit 601 Part 1 (SJR601.1), 1967, Revised 25 May 2011, (HLM 1.98), listed as a 24-inch CMP]. FS Date: 10/6/2020

Concrete headwall and flapgate on WS toe.

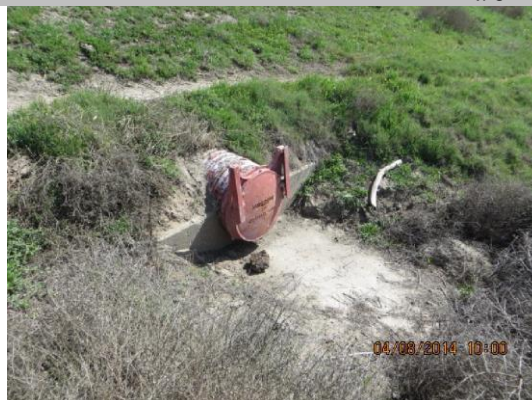
Photo 2 of 3 : UCIP\_SP\_2021\_62622\_60672.jpg

Pipe, flapgate, and headwall on WS toe.

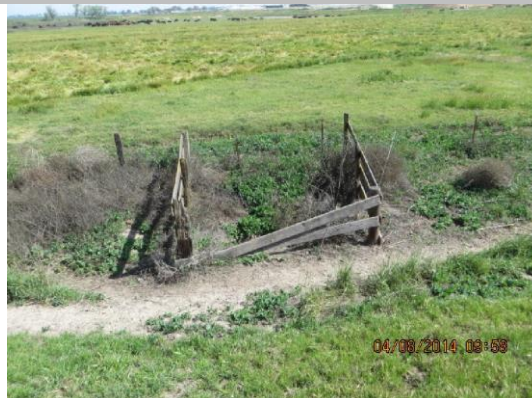
Photo 3 of 3 : UCIP\_SP\_2021\_62622\_60671.jpg

Wooded barrier around drop-inlet on LS toe.

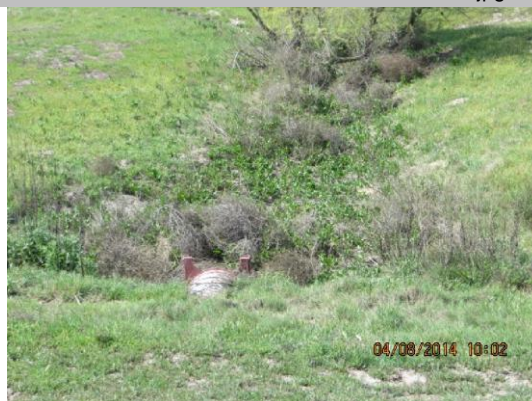
Photo 1 of 3 : UCIP\_SP\_2021\_62623\_60675.jpg

FS\_ID:62623  
DS\_ID:19570  
EP\_NO: N/A  
Repair Type: Non-Urgent  
Crossing Status: Found  
UCIP Comments: 10/06/2020 Pipe status is still Urgent. DWR DMP has found integrity issues, LOF between 4 and 5. Wooden barrier surrounding drop-inlet is dilapidated. Crossing will be monitored until funding becomes available for rehabilitation. No permit was found authorizing this encroachment. CVFPB will need to review crossing to determine owner. (B. Singh - GEI, O. Magana - DWR UCIP)04/08/2014 Unable to find inlet on landward toe. Recommend clearing vegetation on landward side to properly inspect inlet. (W. Wylie - DWR UCIP)  
FIELD\_STRUCT\_DESC: 24-inch corrugated metal gravity drainage pipe through the levee, 9.8 feet below the crown. Flap gate on the waterside (WS) end. Brass cap No. 100 bench mark (BM) on the headwall on the landside (LS). [Additional Reference(s): DWR Levee Log, 2002 (HLM 2.08), listed as a 24-inch corrugated metal pipe (CMP). USACE San Joaquin O&M Manual, Unit 601 Part 1 (SJR601.1), 1967, Revised 25 May 2011, (HLM 2.08), listed as a 24-inch CMP].

Pipe and flapgate visible on WS toe.

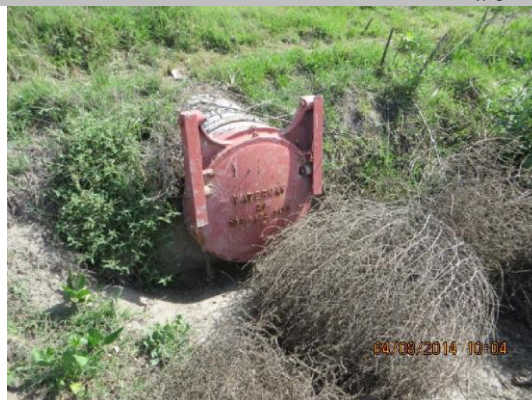
Photo 2 of 3 : UCIP\_SP\_2021\_62623\_60676.jpg

Pipe and flapgate visible on WS toe.

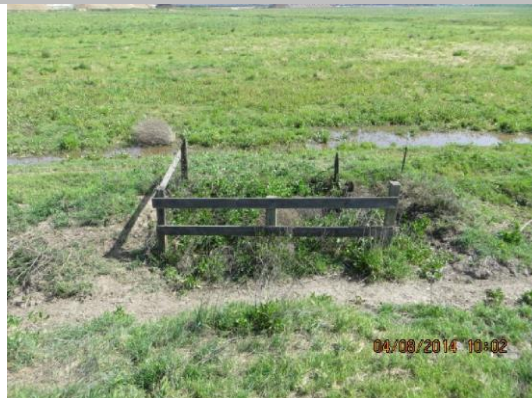
Photo 3 of 3 : UCIP\_SP\_2021\_62623\_60674.jpg

Wooded barrier around drop-inlet on LS toe.

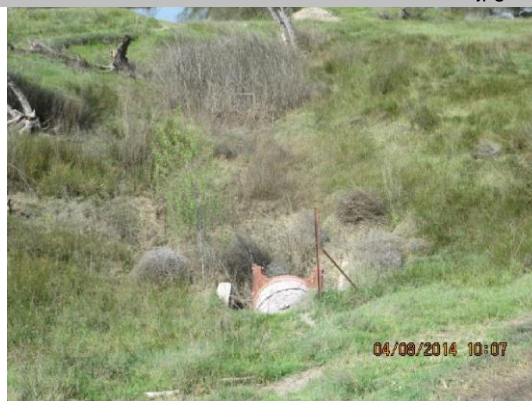
Photo 1 of 3 : UCIP\_SP\_2021\_62637\_71309.jpg

Comment Code						
Inspector Comment						
FS_ID:62637 DS_ID:19571 EP_NO: N/A Repair Type: Non-Urgent Crossing Status: Found UCIP Comments: 10/06/2020 Pipe status is still Non-Urgent. Pipe angle through the levee. No permit was found authorizing this encroachment. CVFPB will need to review crossing to determine owner. DWR DMP has not completed an internal inspection of the pipe but is scheduled for 2021. (B. Singh - GEI, O. Magana - DWR UCIP) FIELD_STRUCT_DESC: 36-inch corrugated metal gravity drainage pipe through the levee, 12.6 feet below the crown. Flap gate on the waterside (WS) end. Brass cap No. 100 bench mark (BM) on the headwall on the landside (LS). Wooden barrier around drop inlet on the LS toe. [Additional Reference(s): DWR Levee Log, 2002 (HLM 2.25), listed as a 36-inch corrugated metal pipe (CMP). USACE San Joaquin O&M Manual, Unit 601 Part 1 (SJR601.1), 1967, Revised 25 May 2011, (HLM 2.25), listed as a 36-inch CMP]. FS Date: 10/6/2020

Pipe and flapgate on WS toe.

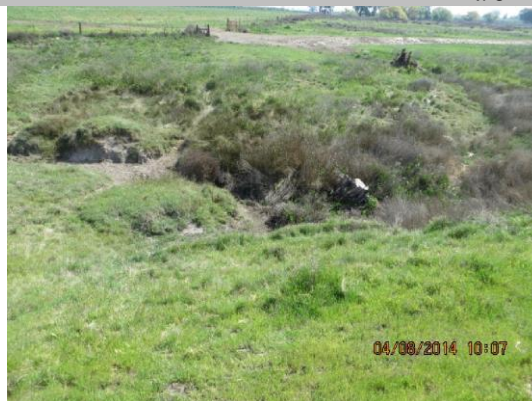
Photo 2 of 3 : UCIP\_SP\_2021\_62637\_71308.jpg

Pipe and headwall on LS toe.

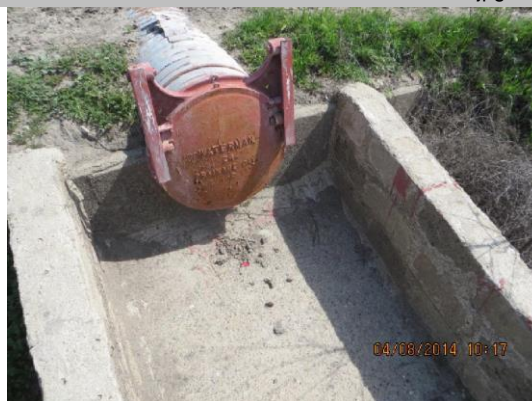
Photo 2 of 3 : UCIP\_SP\_2021\_62625\_60680.jpg

Pipe, headwall, and flapgate on WS toe.

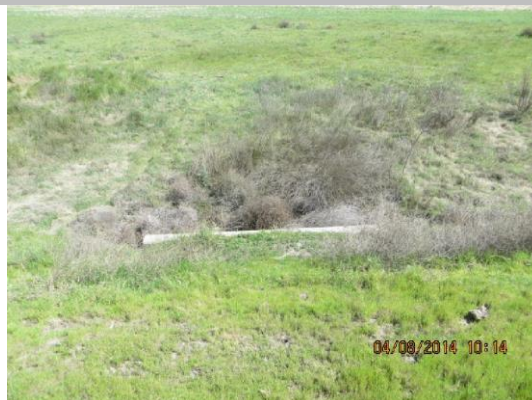
Photo 3 of 3 : UCIP\_SP\_2021\_62625\_60678.jpg

Pipe and headwall on LS toe.

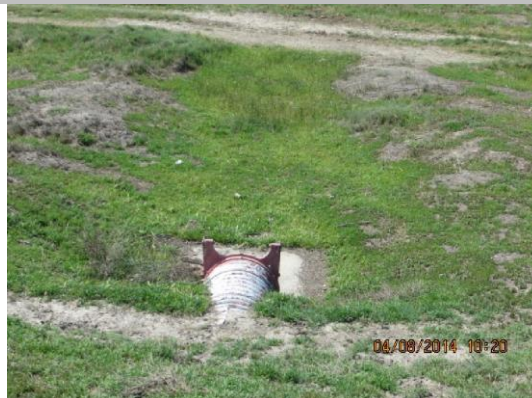
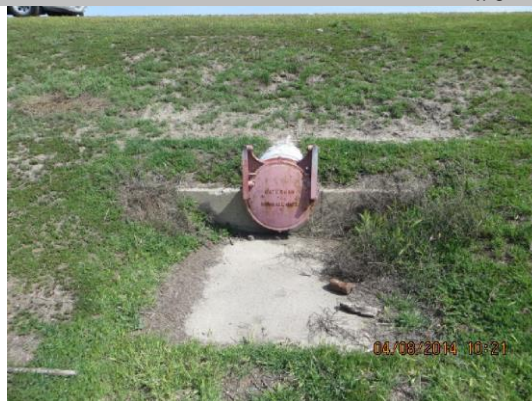
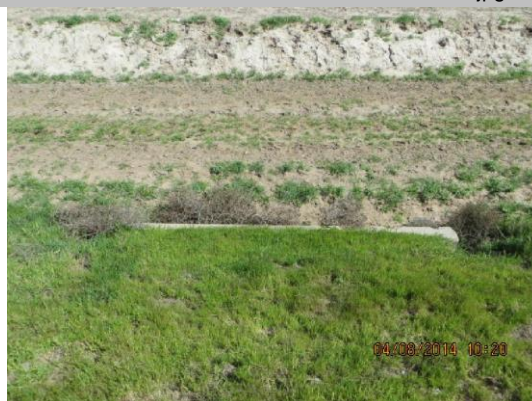
Photo 1 of 3 : UCIP\_SP\_2021\_62626\_60688.jpg

FS\_ID:62626  
DS\_ID:19573  
EP\_NO: N/A  
Repair Type: Non-Urgent  
Crossing Status: Found  
UCIP Comments: 10/06/2020 Pipe status is still Non-Urgent. No permit was found authorizing this encroachment. CVFPB will need to review crossing to determine owner. DWR DMP has not found internal issues, LOF between 1 and 2. Recommend inspection in 5 years. (B. Singh - GEI, O. Magana - DWR UCIP)04/08/2014 Sedimentation in pipe at landward toe. (W. Wylie - DWR UCIP)  
FIELD\_STRUCT\_DESC: 24-inch corrugated metal gravity drainage pipe through the levee, 7.3 feet below the crown. Flap gate on the waterside (WS) end. Brass cap No. 100 bench mark (BM) on the headwall on the landside (LS). [Additional Reference(s): DWR Levee Log, 2002 (HLM 2.71), listed as a 24-inch corrugated metal pipe (CMP). USACE San Joaquin O&M Manual, Unit 601 Part 1 (SJR601.1), 1967, Revised 25 May 2011, (HLM 2.70), listed as a 24-inch CMP].

Pipe, flapgate, and headwall on WS toe.

Pipe and headwall on LS toe.

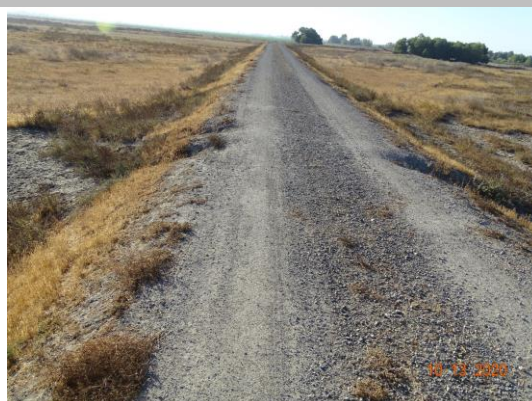
Photo 1 of 1 : SP\_2021\_NA0010\_118\_114\_20210308\_00021.jpg

LM Start	2.99	Rating **	U	Issue No.	114
LM End	2.99	Issue Type +	Ma	Location *	LS
Category	Earthen Levee			GPS Latitude/Longitude	
				Start	End
Item	Animal Control			37.323328 °	37.323328 °
				-120.929521 °	-120.929521 °
DWR ID	DWR_NA0010_01_f_2018_114				
Comment Code					
A2 : Repair the levee slope damaged by livestock and prevent large animal access.					
Inspector Comment					
Slope damage caused by livestock on both landside and waterside slope has eroded into the levee crown.

View of damage to both slope from livestock activity. (Fall 2020)

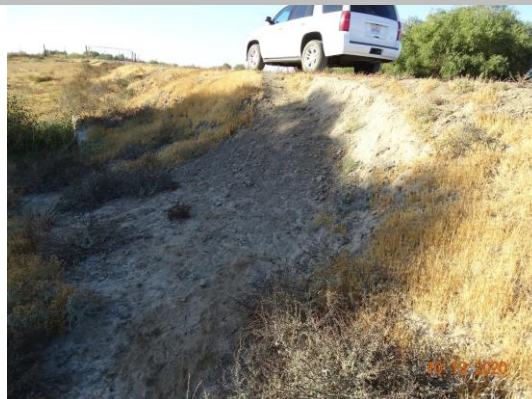
Photo 1 of 1 : SP\_2021\_NA0010\_118\_108\_20210308\_00016.jpg

LM Start	3.13	Rating **	M	Issue No.	108
LM End	3.13	Issue Type +	Ma	Location *	LS
Category	Earthen Levee			GPS Latitude/Longitude	
				Start	End
Item	Animal Control			37.321488 °	37.321488 °
				-120.928758 °	-120.928758 °
DWR ID	DWR_NA0010_01_s_2017_108				
Comment Code					
A2 : Repair the levee slope damaged by livestock and prevent large animal access.					
Inspector Comment					
Slope damage caused by animal traffic on landside toe.

View of landside slope damage by animal traffic. (Fall 2020)

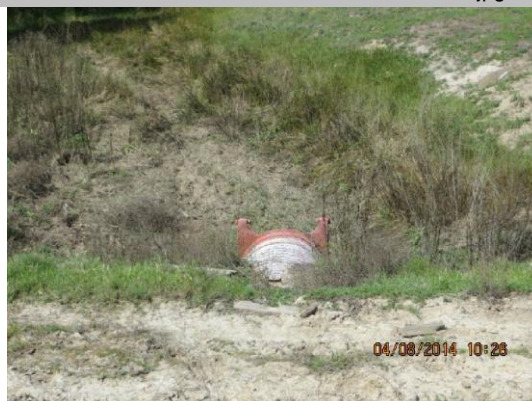
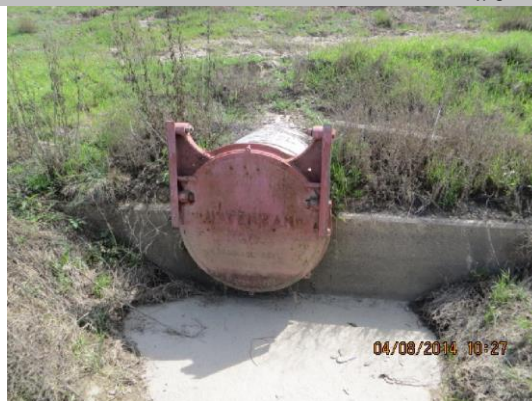
Photo 1 of 3 : UCIP\_SP\_2021\_62627\_60702.jpg

FS\_ID:62627  
DS\_ID:19574  
EP\_NO: N/A  
Repair Type: Non-Urgent  
Crossing Status: Found  
UCIP Comments: 10/06/2020 Pipe status is still Non-Urgent. No permit was found authorizing this encroachment. CVFPB will need to review crossing to determine owner. DWR DMP has not completed an internal inspection of the pipe but is scheduled for 2021. (B. Singh - GEI, O. Magana - DWR UCIP)04/08/2014 Some minor erosion around headwall on LS toe. (W. Wylie - DWR UCIP)  
FIELD\_STRUCT\_DESC: 36-inch corrugated metal gravity drainage pipe through the levee, 8 feet below the crown. Flap gate on the waterside (WS) end. Brass cap No. 100 bench mark (BM) on the headwall on the landside (LS). [Additional Reference(s): DWR Levee Log, 2002 (HLM 3.17), listed as a 36-inch corrugated metal pipe (CMP). USACE San Joaquin O&M Manual, Unit 601 Part 1 (SJR601.1), 1967, Revised 25 May 2011, (HLM 3.16), listed as a 36-inch CMP].

Pipe, Flapgate, and headwall on WS toe.

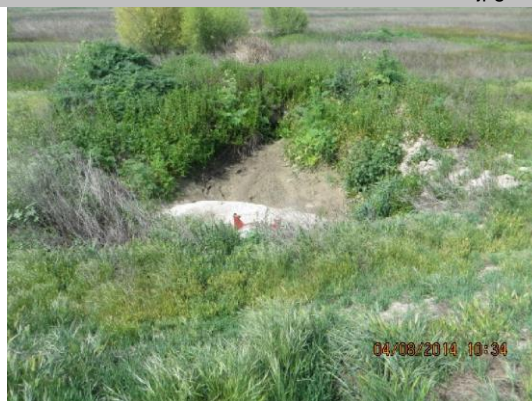
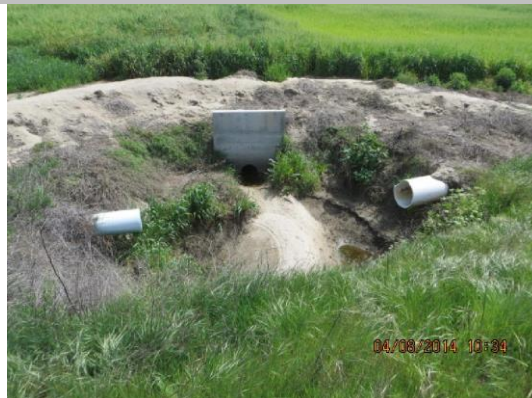
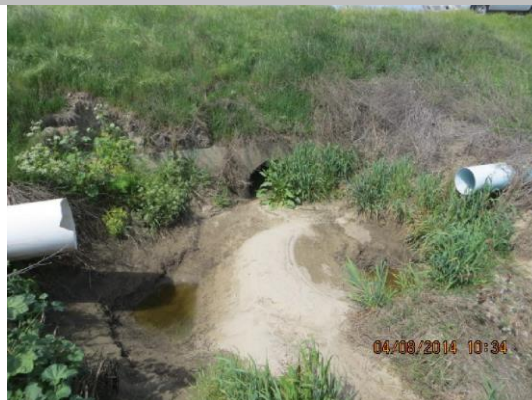
Photo 1 of 3 : UCIP\_SP\_2021\_62621\_60707.jpg

Comment Code						
Inspector Comment						
FS_ID:62621 DS_ID:19575 EP_NO: N/A Repair Type: Urgent Crossing Status: Found UCIP Comments: 10/06/2020 Pipe status is still Urgent. Sinkhole present directly above LS toe headwall along pipe alignment. Pipe collapse visible from LS toe. No permit was found authorizing this encroachment. CVFPB will need to review crossing to determine owner. DWR DMP has not completed an internal inspection of the pipe but is scheduled for 2021. (B. Singh - GEI, O. Magana - DWR UCIP)11/01/2018 Pipe continues to rust through, causing the pipe to collapse on the LS. Sediment buildup visible from the LS inlet. Loss of soil just above the LS concrete headwall and along the LS slope. Crossing remains Urgent due to the levee slope issues and pipe failure through the levee. (O. Magana - DWR UCIP)07/19/2016 Same as previous inspection. Erosion present on LS slope. (O. Magana - DWR UCIP)04/08/2014 Pipe rusted through at Springline on LS toe. Flapgate blocked by sediment on WS toe. Heavy sediment on both ends of pipe. Need to contact owner to address issues. (W. Wylie - DWR UCIP) FIELD_STRUCT_DESC: 36-inch corrugated metal gravity drainage pipe through the levee, 9.7 feet below the crown. Flap gate on the waterside (WS) end. Brass cap No. 100 bench mark (BM) on the headwall on the landside (LS). [Additional Reference(s): DWR Levee Log, 2002 (HLM 3.50), listed as a 36-inch corrugated metal pipe (CMP). USACE San Joaquin O&M Manual, Unit 601 Part 1 (SJR601.1), 1967, Revised 25 May 2011, (HLM 3.50), listed as a 36-inch CMP]. FS Date: 10/6/2020

Pipe, headwall, and flapgate on WS toe.

Pipe and headwall on LS toe.

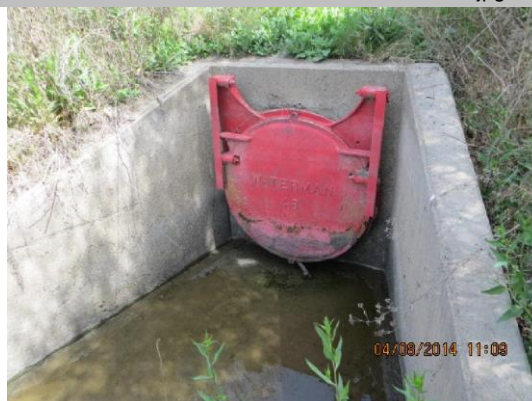
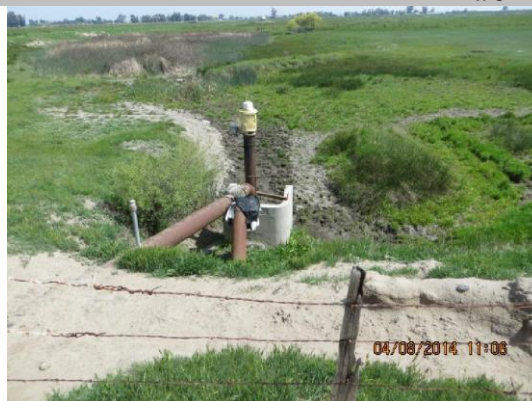
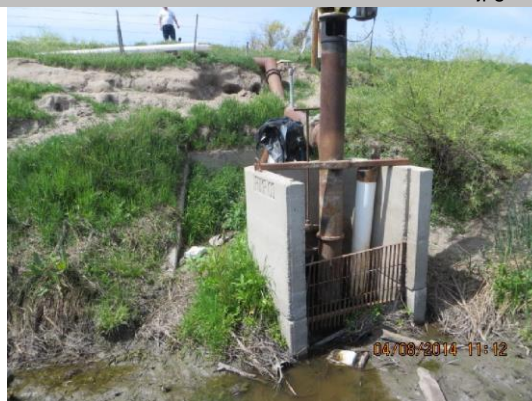
Photo 1 of 3 : UCIP\_SP\_2021\_62651\_60730.jpg

FS\_ID:62651  
DS\_ID:19607  
EP\_NO: N/A  
Repair Type: Non-Urgent  
Crossing Status: Found  
UCIP Comments: 10/20/2020 Barbed wire inhibiting access to pipe at LS toe. Unpermitted modifications made to structure. Recommend new DSID and removal for seemingly abandoned 12" metal pipe through levee, approximately 1 foot below crown at CLM 4.131. Visible at LS structure. Recommend DMP inspection. No permit was found authorizing these encroachments. CVFPB will need to review crossing to determine owner(s). (B. Singh - GEI, O. Magana - DWR UCIP)04/08/2014 Pipe appears sleeved with a 12-inch steel pipe with a slide gate at the LS toe. No identified authorization for changes to this crossing. Need to contact owner to obtain additional information about the modifications to crossing. (W. Wylie - DWR UCIP)  
FIELD\_STRUCT\_DESC: 48-inch corrugated metal gravity drainage pipe through the levee, 14 feet below the crown. Flap gate on the waterside (WS) end. Brass cap No. 90 bench mark (BM) on the headwall on the landside (LS). [Additional Reference(s): DWR Levee Log, 2002 (HLM 4.16), listed as a 48-inch pipe. USACE San Joaquin O&M Manual, Unit 601 Part 1 (SJR601.1), 1967, Revised 25 May 2011, (HLM 4.16), listed as a 48-inch corrugated metal pipe (CMP)].

Concrete headwall and 48-inch flapgate visible on WS toe.

Assumed pipe exists under pump at LS toe.

Concrete inlet, slidegate, and concrete headwall at LS toe.

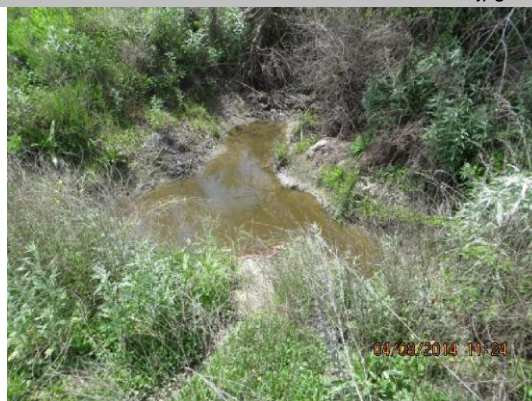
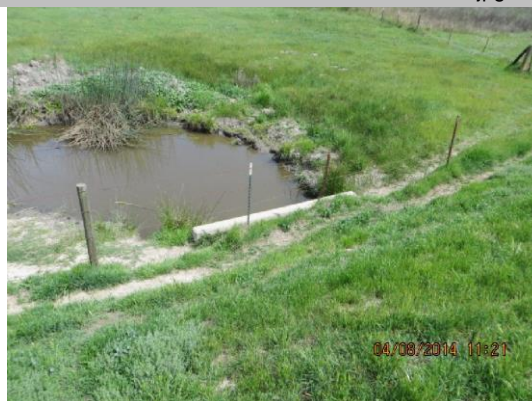
Photo 1 of 3 : UCIP\_SP\_2021\_62632\_60733.jpg

Comment Code						
Inspector Comment						
FS_ID:62632 DS_ID:19608 EP_NO: N/A Repair Type: Non-Urgent Crossing Status: Found UCIP Comments: 10/20/2020 Fence and dense vegetation inhibiting slope inspection. Burrowing observed on LS and WS slopes. Pipe status is still Non-Urgent. No permit was found authorizing this encroachment. CVFPB will need to review crossing to determine owner. DWR DMP has not completed an internal inspection of the pipe but is scheduled for 2021. (B. Singh - GEI, O. Magana - DWR UCIP)04/08/2014 Dense vegetation and fence limits the inspector's visibility to identify signs of pipe failure (leaks) along the landward side. Recommend obtaining access to landward toe and removing vegetation along pipe alignment to conduct proper inspection of structure and appurtenances. (W. Wylie - DWR UCIP) FIELD_STRUCT_DESC: 24-inch corrugated metal gravity drainage pipe through the levee, 11.9 feet below the crown. Flap gate on the waterside (WS) end. Brass cap No. 90 bench mark (BM) on the headwall on the landside (LS). [Additional Reference(s): DWR Levee Log, 2002 (HLM 4.27), listed as a 24-inch corrugated metal pipe (CMP). USACE San Joaquin O&M Manual, Unit 601 Part 1 (SJR601.1), 1967, Revised 25 May 2011, (HLM 4.27), listed as a 24-inch CMP]. FS Date: 10/20/2020

Pipe, flapgate, and headwall visible at WS toe.

Concrete headwall at LS toe.

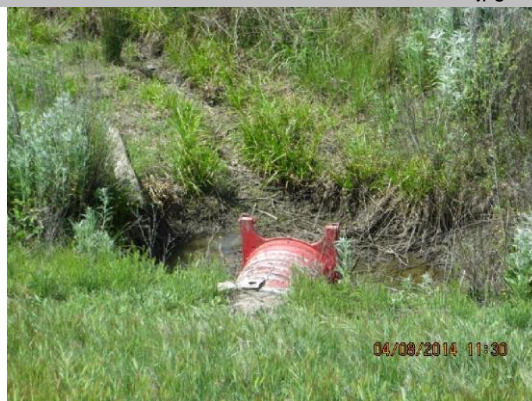
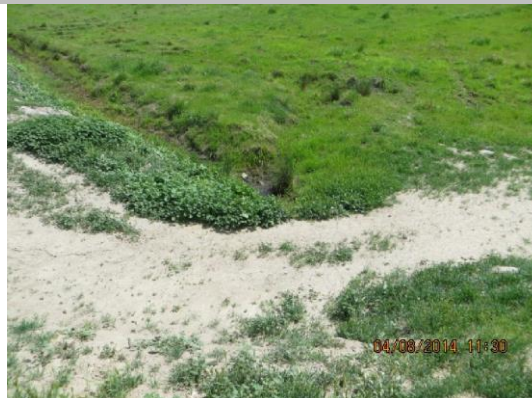
Photo 1 of 3 : UCIP\_SP\_2021\_62633\_60737.jpg

Comment Code						
Inspector Comment						
FS_ID:62633 DS_ID:19609 EP_NO: N/A Repair Type: Urgent Crossing Status: Found UCIP Comments: 10/20/2020 Pipe status is still Urgent. DWR DMP has found integrity issues, LOF between 4 and 5. Crossing will be monitored until funding becomes available for rehabilitation or removal. Evidence of landslide of LS slope from crown. No permit was found authorizing this encroachment. CVFPB will need to review crossing to determine owner. (B. Singh - GEI, O. Magana - DWR UCIP)04/08/2014 Dense vegetation limits the inspector's visibility to identify signs of pipe failure (leaks) along the waterward side. Recommend removing vegetation along pipe alignment to conduct proper inspection of structure and appurtenances. (W. Wylie - DWR UCIP) FIELD_STRUCT_DESC: 24-inch corrugated metal gravity drainage pipe through the levee, 10 feet below the crown. Flap gate on the waterside (WS) end. Brass cap No. 90 bench mark (BM) on the headwall on the landside (LS). [Additional Reference(s): DWR Levee Log, 2002 (HLM 4.73), listed as a 24-inch corrugated metal pipe (CMP). USACE San Joaquin O&M Manual, Unit 601 Part 1 (SJR601.1), 1967, Revised 25 May 2011, (HLM 4.72), listed as a 24-inch CMP]. FS Date: 10/20/2020

Pipe, flapgate, and headwall on WS toe.

Pipe and concrete headwall on LS toe.

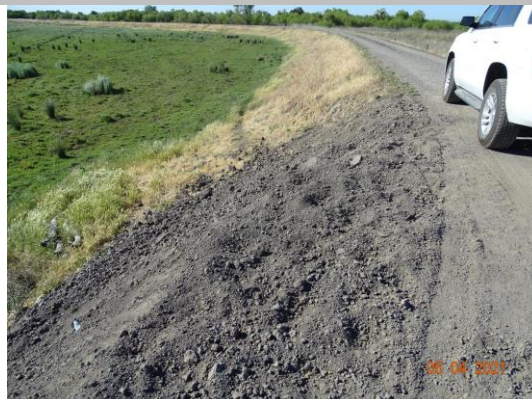
Photo 1 of 1 : SP\_2021\_NA0010\_118\_9\_20210517\_00304.jpg

LM Start	4.69	Rating **	A/W	Issue No.	9
LM End	4.69	Issue Type +	Ma	Location *	LS
Category	Earthen Levee			GPS Latitude/Longitude	
				Start	End
Item	Animal Control			37.302398 °	37.302398 °
				-120.920920 °	-120.920920 °
DWR ID	DWR_NA0010_01_s_2013_9				
Comment Code					
A2 : Repair the levee slope damaged by livestock and prevent large animal access.					
Inspector Comment					
Damage has been repaired. Backfill appears loosely compacted, monitor for potential settlement.

View of repaired slope damage on the landside. (Spring 2021)

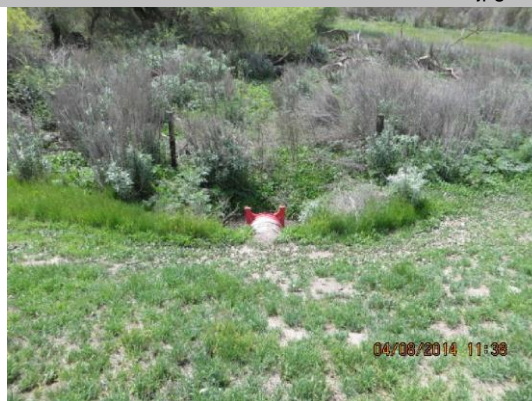
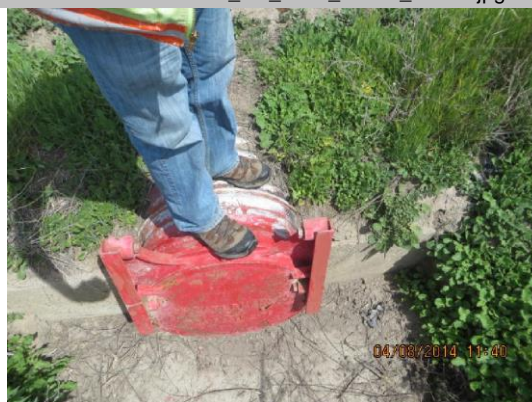
Photo 1 of 3 : UCIP\_SP\_2021\_62634\_60740.jpg

FS\_ID:62634  
DS\_ID:19610  
EP\_NO: N/A  
Repair Type: Non-Urgent  
Crossing Status: Found  
UCIP Comments: 10/20/2020 Pipe not visible on LS, high vegetation limiting inspections. Pipe status is still Non-Urgent. No permit was found authorizing this encroachment. CVFPB will need to review crossing to determine owner. DWR DMP has not completed an internal inspection of the pipe but is scheduled for 2021. (B. Singh - GEI, O. Magana - DWR UCIP)04/08/2014 Non-functional -- sediment buildup against flapgate and inlet buried at landward side. (W. Wylie - DWR UCIP)  
FIELD\_STRUCT\_DESC: 24-inch corrugated metal gravity drainage pipe through the levee, 8 feet below the crown. Flap gate on the waterside (WS) end. Brass cap No. 90 bench mark (BM) on the headwall on the landside (LS). [Additional Reference(s): DWR Levee Log, 2002 (HLM 5.06), listed as a 24-inch corrugated metal pipe (CMP). USACE San Joaquin O&M Manual, Unit 601 Part 1 (SJR601.1), 1967, Revised 25 May 2011, (HLM 5.05), listed as a 24-inch CMP].

Flapgate and headwall visible at WS toe.

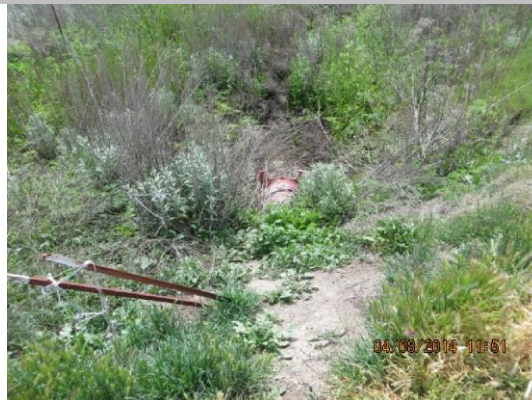
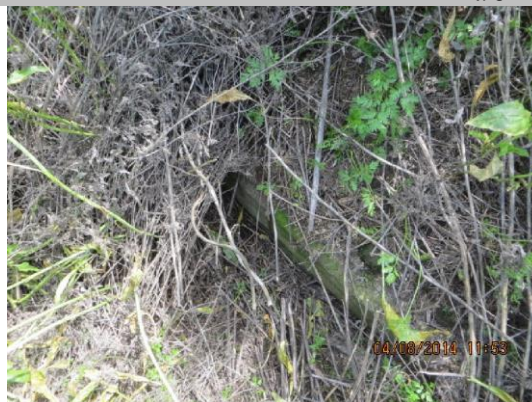
Photo 1 of 3 : UCIP\_SP\_2021\_62650\_60742.jpg

FS\_ID:62650  
DS\_ID:19611  
EP\_NO: N/A  
Repair Type: Non-Urgent  
Crossing Status: Found  
UCIP Comments: 10/20/2020 Pipe status is still non-urgent. Depression observed across levee crown, less than 6 inches in depth. Pipe at LS completely blocked by soil. Dense vegetation inhibiting proper inspection. Recommend soil and vegetation removal. No permit was found authorizing this encroachment. CVFPB will need to review crossing to determine owner. DWR DMP has not completed an internal inspection of the pipe but is scheduled for 2021. (B. Singh - GEI, O. Magana - DWR UCIP)04/08/2014 Dense vegetation limits the inspector's visibility to identify signs of pipe failure (leaks) along waterward and landward slopes. Recommend removing vegetation along pipe alignment to conduct proper inspection of structure and appurtenances. Landward side filled in with soil. Need to contact owner. If crossing is no longer used need to coordinate with CVFPB for proper abandonment. (W. Wylie - DWR UCIP)

Pipe, concrete headwall, and flapgate visible on WS toe.

Top of concrete headwall just visible on LS toe.

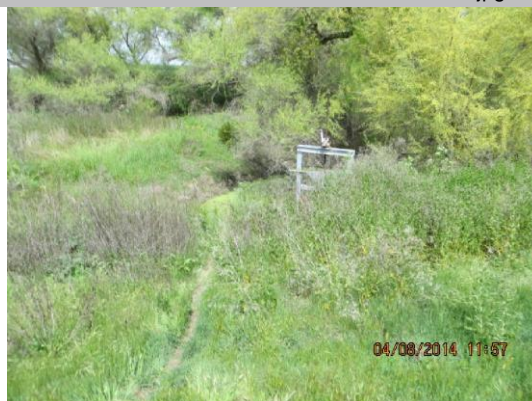
Photo 1 of 3 : UCIP\_SP\_2021\_62636\_60745.jpg

Item	DWR UCIP LMA Responsibility		37.304232 °	37.304232 °								
			-120.900706 °	-120.900706 °								
DWR ID	19612											
Comment Code												
Inspector Comment												
FS_ID:62636 DS_ID:19612 EP_NO: N/A Repair Type: Non-Urgent Crossing Status: Found UCIP Comments: 10/20/2020 Dense vegetation inhibited proper inspections. Recommend vegetation removal. Pipe angled through levee. Scour observed on LS toe surrounding headwall. Pipe status is still Non-Urgent. No permit was found authorizing this encroachment. CVFPB will need to review crossing to determine owner. DWR DMP has not completed an internal inspection of the pipe but is scheduled for 2021. (B. Singh - GEI, O. Magana - DWR UCIP)04/08/2014 Dense vegetation limits the inspector's visibility to identify signs of pipe failure (leaks) along waterward and landward slopes. Recommend removing vegetation along pipe alignment to conduct proper inspection of structure and appurtenances. Pipe completely blocked by soil on LS toe due to animal activity. Slide gate blocked open. (W. Wylie - DWR UCIP) FIELD_STRUCT_DESC: 48-inch corrugated metal gravity drainage pipe through the levee, 13.1 feet below the crown. Walkway to slide gate at the concrete headwall on the landside (LS) toe. Flap gate at the concrete headwall on the waterside (WS) toe. Brass cap No. 90 bench mark (BM) on the headwall on the LS. Pipe crosses the levee at an angle. [Additional Reference(s): DWR Levee Log, 2002 (HLM 6.13), listed as a 48-inch corrugated metal pipe (CMP). USACE San Joaquin O&M Manual, Unit 601 Part 1 (SJR601.1), 1967, Revised 25 May 2011, (HLM 6.13), listed as a 48-inch CMP]. FS Date: 10/20/2020

Slidegate at LS toe.

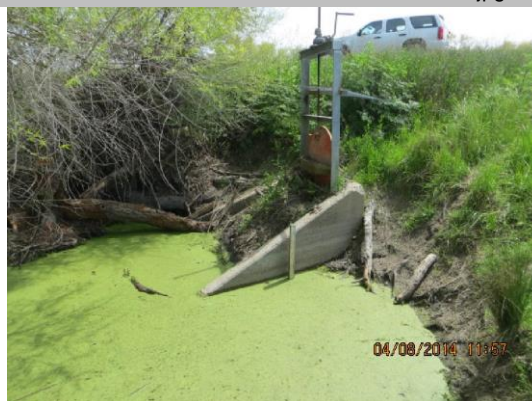
Photo 2 of 3 : UCIP\_SP\_2021\_62636\_60744.jpg

Pipe, concrete headwall, slidegate, and metal walkway on LS toe.

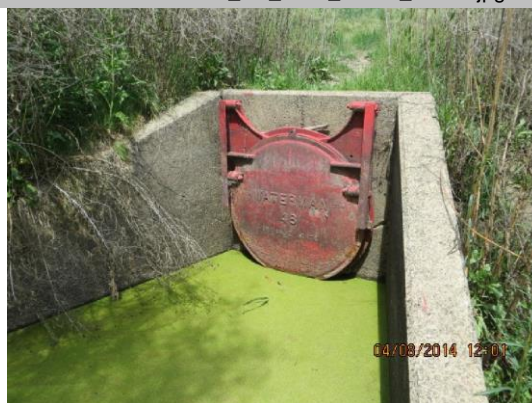
Photo 3 of 3 : UCIP\_SP\_2021\_62636\_60743.jpg

Flapgate on concrete headwall at WS toe.

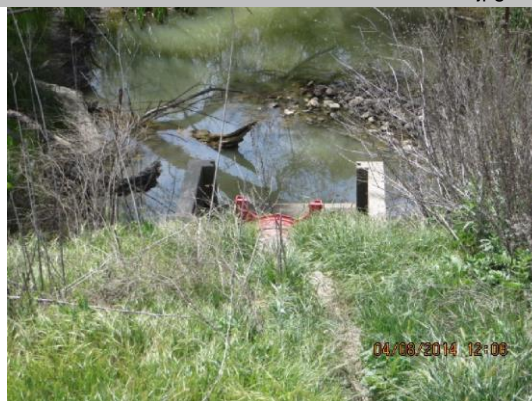
Photo 1 of 3 : UCIP\_SP\_2021\_62638\_60762.jpg

FS\_ID:62638  
DS\_ID:19613  
EP\_NO: N/A  
Repair Type: Non-Urgent  
Crossing Status: Found  
UCIP Comments: 10/20/2020 Pipe status is still Non-Urgent. Dense vegetation on WS toe, recommend removal for proper inspection. Minor scour visible on LS toe near standpipe. No permit was found authorizing this encroachment. CVFPB will need to review crossing to determine owner. DWR DMP has not completed an internal inspection of the pipe but is scheduled for 2021. (B. Singh - GEI, O. Magana - DWR UCIP)04/08/2014 Dense vegetation limits the inspector's visibility to identify signs of pipe failure (leaks) along the slope. Recommend removing vegetation along pipe alignment to conduct proper inspection of structure and appurtenances. (W. Wylie - DWR UCIP)  
FIELD\_STRUCT\_DESC: 24-inch corrugated metal gravity drainage pipe through the levee, 9.5 feet below the crown. Flap gate on the waterside (WS) end. Slide gate on the landside (LS) end next to a 48-inch concrete riser with walkway over the top. Brass cap No. 90 bench mark (BM) on the headwall on the LS. [Additional Reference(s): DWR Levee Log, 2002 (HLM 6.44), listed as a 24-inch corrugated metal pipe (CMP). USACE San Joaquin O&M Manual, Unit 601 Part 1 (SJR601.1), 1967, Revised 25 May 2011, (HLM 6.40), listed as a 24-inch CMP].

Pipe, flapgate, and concrete headwall on WS toe.

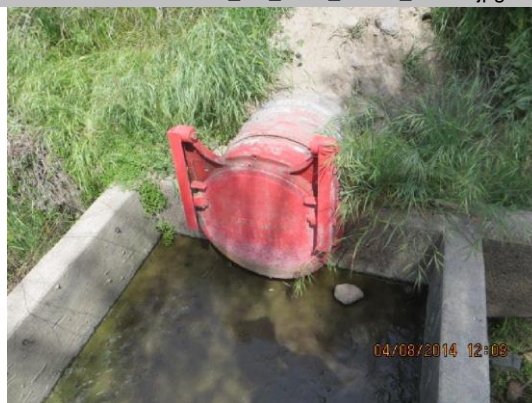
Photo 2 of 3 : UCIP\_SP\_2021\_62638\_60760.jpg

Pipe, flapgate, and concrete headwall on WS toe.

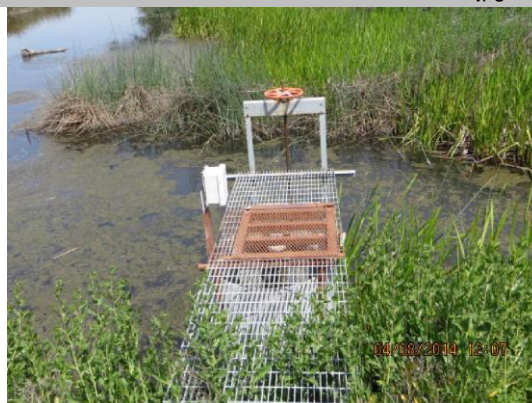
Photo 3 of 3 : UCIP\_SP\_2021\_62638\_60761.jpg

Metal walkway over concrete standpipe next to slide gate on LS toe.

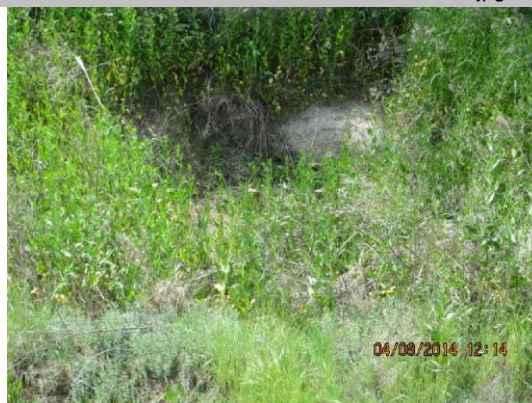
Photo 1 of 3 : UCIP\_SP\_2021\_62639\_60764.jpg

FS\_ID:62639  
DS\_ID:19614  
EP\_NO: N/A  
Repair Type: Non-Urgent  
Crossing Status: Found  
UCIP Comments: 10/20/2020 Pipe status is still Non-Urgent, but DMP inspection is recommended. Dense vegetation inhibits inspection of pipe at LS toe, and both slopes. No permit was found authorizing this encroachment. CVFPB will need to review crossing to determine owner. (B. Singh - GEI, O. Magana - DWR UCIP)7/19/2016 Same as previous inspection. Outlet and inlet are under water. (O. Magana - DWR UCIP)4/08/2014 Flapgate blocked by sedimentation at WS toe. Dense vegetation limits the inspector's visibility to identify signs of pipe failure (leaks) along the slope. Recommend removing vegetation along pipe alignment to conduct proper inspection of structure and appurtenances. Also recommend clearing vegetation from both waterward and landward toe. (W. Wylie - DWR UCIP)  
FIELD\_STRUCT\_DESC: 24-inch corrugated metal gravity drainage pipe through the levee, 9.8 feet below the crown. Wooden fence around a 4-foot by 4-foot drop inlet on the landside (LS) toe. Flap gate on the waterside (WS) end. Brass cap No. 90 bench mark (BM) on the headwall on the LS. [Additional Reference(s): DWR Levee Log, 2002 (HLM 6.65), listed as a 24-inch corrugated metal pipe (CMP). USACE San Joaquin O&M Manual, Unit 601 Part 1 (SJR601.1), 1967, Revised 25 May 2011, (HLM 6.64), listed as a 24-inch CMP].

Pipe and flapgate visible on WS toe.

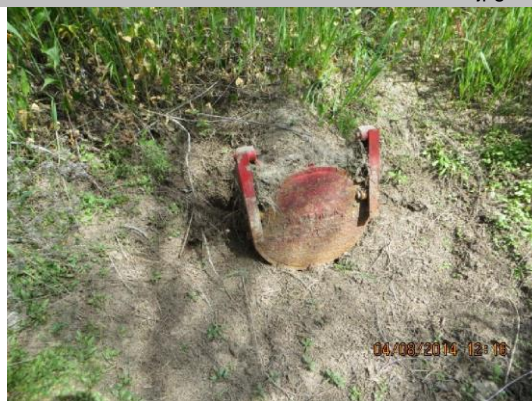
Photo 2 of 3 : UCIP\_SP\_2021\_62639\_60766.jpg

Pipe and flapgate visible at WS toe. Flapgate blocked by sedimentation on WS toe.

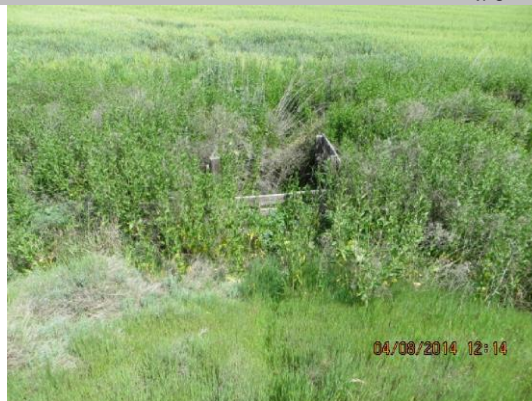
Photo 3 of 3 : UCIP\_SP\_2021\_62639\_60765.jpg

Wooden barrier around drop inlet on LS toe. Excess vegetation.

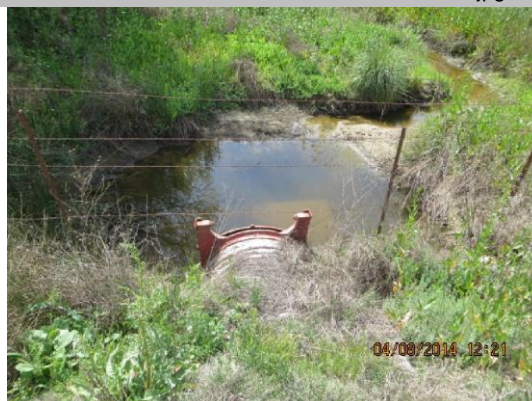
Photo 1 of 3 : UCIP\_SP\_2021\_62642\_60768.jpg

Comment Code						
Inspector Comment						
FS_ID:62642 DS_ID:19615 EP_NO: N/A Repair Type: Urgent Crossing Status: Found UCIP Comments: 10/20/2020 Pipe status is Urgent. Surface erosion present on LS slope. Corrosion through pipe near flapgate and surface erosion at WS toe. Plastic sheeting was placed approximately 15 feet downstream of the pipe to prevent further erosion. Recommend DMP inspection. Crossing will continued to be monitored. No permit was found authorizing this encroachment. CVFPB will need to review crossing to determine owner. (B. Singh - GEI, O. Magana - DWR UCIP)7/19/2016 Potential LS slope damage--difficult to determine due to dense vegetation. Limited access on WS toe due to wire fence. (O. Magana - DWR UCIP)4/08/2014 Slide gate blocked by debris at LS toe. Flapgate won't close because of debris. Dense vegetation limits the inspector's visibility to identify signs of pipe failure (leaks) along the slope. Recommend removing vegetation along pipe alignment to conduct proper inspection of structure and appurtenances. (W. Wylie - DWR UCIP) FIELD_STRUCT_DESC: 36-inch corrugated metal gravity drainage pipe through the levee, 10.3 feet below the crown. Slide gate on the landside (LS) toe. Flap gate on the waterside (WS) end. Brass cap No. 90 bench mark (BM) on the headwall on the LS. [Additional Reference(s): DWR Levee Log, 2002 (HLM 6.90), listed as a 36-inch corrugated metal pipe (CMP). USACE San Joaquin O&M Manual, Unit 601 Part 1 (SJR601.1), 1967, Revised 25 May 2011, (HLM 6.90), listed as a 36-inch CMP]. FS Date: 10/20/2020

Pipe, headwall, and flapgate on WS toe.

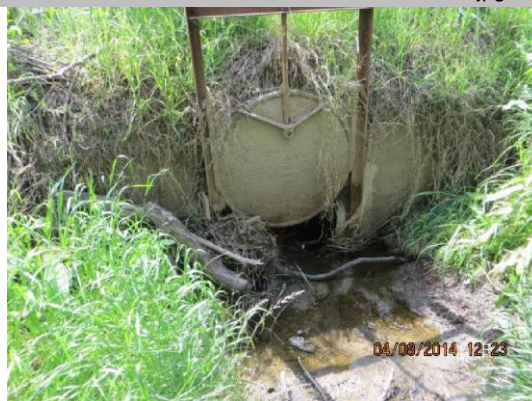
Photo 2 of 3 : UCIP\_SP\_2021\_62642\_60767.jpg

Pipe, concrete headwall, and slidegate on LS toe. Debris blocking closure of slidegate.
