**Flood Control Project Maintenance  
Levee Inspections**

## Maintenance Issue Types Only, Levee Inspection Report By Mile - Spring 2021

### Lower San Joaquin Levee District

Waterway	Bank	Unit Miles	Inspection Start/End	Inspector
Unit No. 01 San Joaquin River	Right	22.52	05/04/2021 05/04/2021	Corey Fujitani

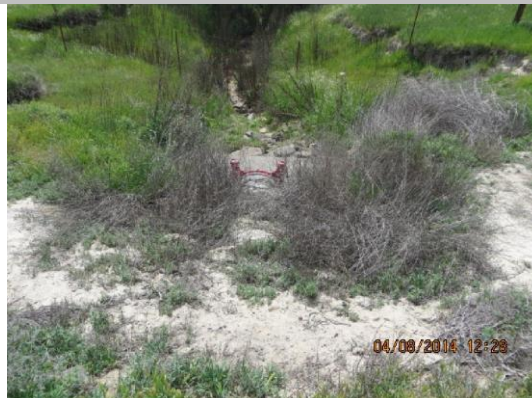
Photo 1 of 3 : UCIP\_SP\_2021\_62641\_60770.jpg

UCIP Comments: 10/20/2020 Pipe status is still Urgent - recommend replacement. DWR DMP has found integrity issues, LOF between 5 and 6. Pipe deeply corroded. Crossing will be monitored until funding becomes available for removal. No permit was found authorizing this encroachment. CVFPB will need to review crossing to determine owner. (B. Singh - GEI, O. Magana - DWR UCIP)11/01/2018 Pipe continues to corrode through. Voids (undermining) along pipe invert are visible from the LS. Potential undermining caused by erosion under concrete apron on the WS. Crossing remains Urgent due to the pipe failure. (O. Magana - DWR UCIP)04/08/2014 Pipe failing and corroded through at LS toe. Need to contact owner to determine status of crossing. Also dense vegetation limits the inspector's visibility to identify signs of pipe failure (leaks) along the landward slope. Recommend removing vegetation along pipe alignment to conduct proper inspection of structure. (W. Wylie - DWR UCIP)

Pipe, concrete headwall, and flapgate on WS toe.

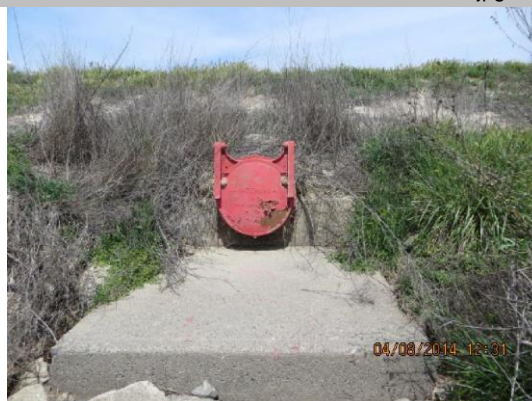
Photo 2 of 3 : UCIP\_SP\_2021\_62641\_60772.jpg

Flapgate and concrete headwall on WS toe.

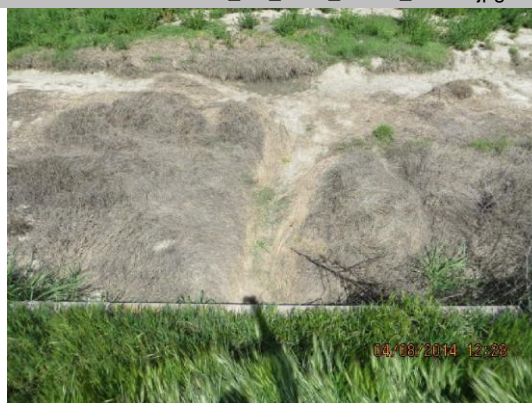
Photo 3 of 3 : UCIP\_SP\_2021\_62641\_60771.jpg

Pipe and Concrete headwall visible on LS toe.

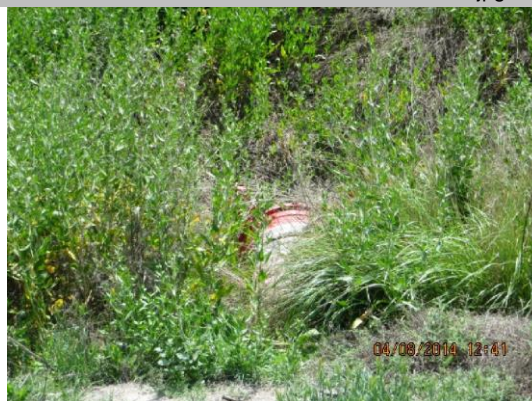
Photo 1 of 3 : UCIP\_SP\_2021\_62644\_60778.jpg

Comment Code					
Inspector Comment					
FS_ID:62644 DS_ID:19618 EP_NO: N/A Repair Type: Urgent Crossing Status: Found UCIP Comments: 10/20/2020 Pipe status is Urgent. DWR DMP has found integrity issues, LOF between 5 and 6. Crossing will be monitored until funding becomes available for removal. No permit was found authorizing this encroachment. CVFPB will need to review crossing to determine owner. (B. Singh - GEI, O. Magana - DWR UCIP)04/08/2014 Dense vegetation limits the inspector's visibility to identify signs of pipe failure (leaks) along the slope. Recommend removing vegetation along pipe alignment to conduct proper inspection of structure and appurtenances. (W. Wylie - DWR UCIP) FIELD_STRUCT_DESC: 24-inch corrugated metal gravity drainage pipe through the levee, 8 feet below the crown. Flap gate on the waterside (WS) end. Brass cap No. 80 bench mark (BM) on the headwall on the landside (LS). [Additional Reference(s): DWR Levee Log, 2002 (HLM 7.46), listed as a corrugated metal pipe (CMP). USACE San Joaquin O&M Manual, Unit 601 Part 1 (SJR601.1), 1967, Revised 25 May 2011, (HLM 7.46), listed as a 24-inch CMP]. FS Date: 10/20/2020

Pipe and flapgate visible on WS toe.

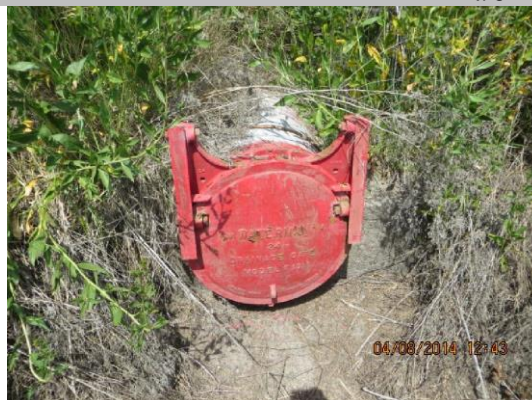
Photo 2 of 3 : UCIP\_SP\_2021\_62644\_60780.jpg

Pipe and flapgate visible on WS toe.

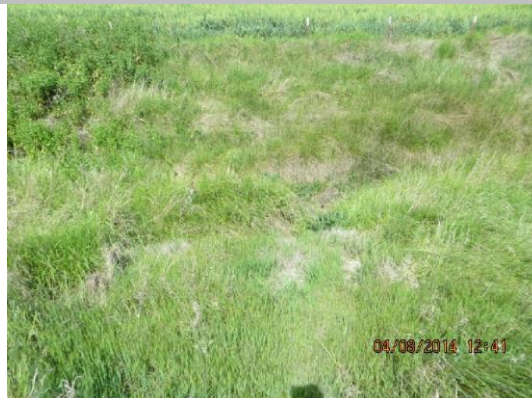
Photo 3 of 3 : UCIP\_SP\_2021\_62644\_60779.jpg

Concrete headwall and pipe visible off LS toe in heavy vegetation.

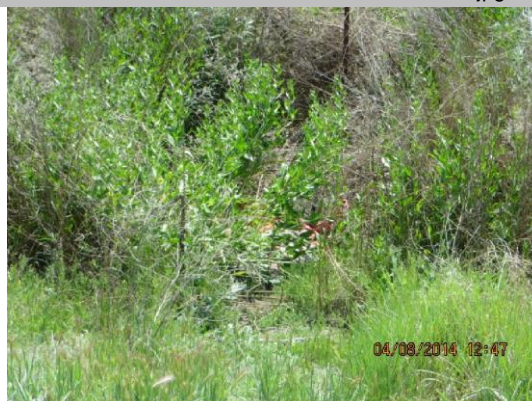
Photo 1 of 3 : UCIP\_SP\_2021\_62653\_60842.jpg

FS\_ID:62653  
DS\_ID:19619  
EP\_NO: N/A  
Repair Type: Urgent  
Crossing Status: Found  
UCIP Comments: 10/20/2020 Pipe status is Urgent. Sloughing observed above pipe and headwall on LS slope. DWR DMP has found integrity issues, LOF between 5 and 6. Crossing will be monitored until funding becomes available for removal. No permit was found authorizing this encroachment. CVFPB will need to review crossing to determine owner. (B. Singh - GEI, O. Magana - DWR UCIP)04/08/2014 Dense vegetation limits the inspector's visibility to identify signs of pipe failure (leaks) along the slope. Recommend removing vegetation along pipe alignment to conduct proper inspection of structure. (W. Wylie - DWR UCIP)  
FIELD\_STRUCT\_DESC: 24-inch corrugated metal gravity drainage pipe through the levee, 10 feet below the crown. Flap gate on the waterside (WS) end. Brass cap No. 80 bench mark (BM) on the headwall on the landside (LS). [Additional Reference(s): DWR Levee Log, 2002 (HLM 7.70), listed as a 24-inch corrugated metal pipe (CMP). USACE San Joaquin O&M Manual, Unit 601 Part 1 (SJR601.1), 1967, Revised 25 May 2011, (HLM 7.69), listed as a 24-inch CMP].

Flapgate and headwall at WS toe. Heavy vegetation on slopes.

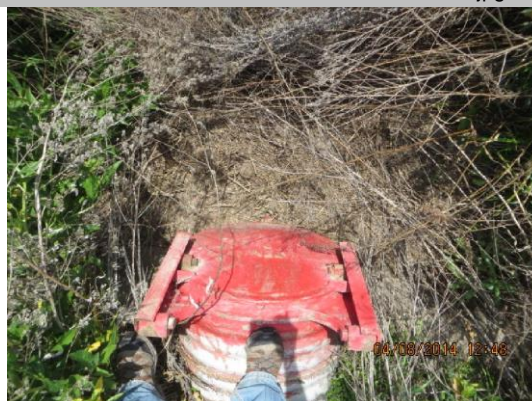
Photo 2 of 3 : UCIP\_SP\_2021\_62653\_60840.jpg

Flapgate and headwall at WS toe.

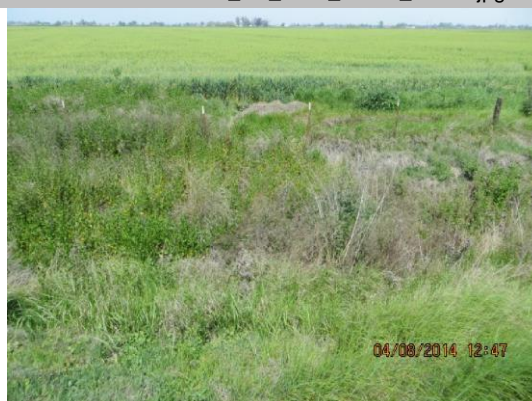
Photo 3 of 3 : UCIP\_SP\_2021\_62653\_60841.jpg

Concrete headwall at LS toe. Heavy vegetation on both slopes.

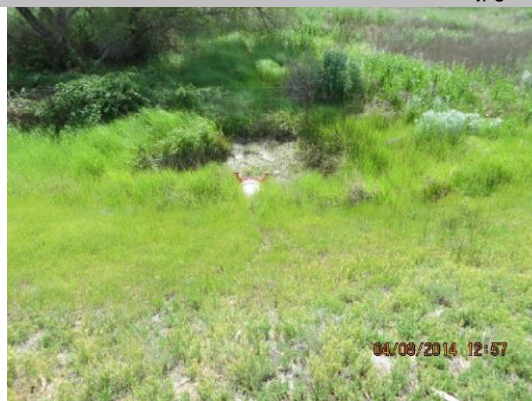
Photo 1 of 3 : UCIP\_SP\_2021\_62654\_60844.jpg

Comment Code					
Inspector Comment					
FS_ID:62654 DS_ID:19620 EP_NO: N/A Repair Type: Urgent Crossing Status: Found UCIP Comments: 10/20/2020 Pipe status is Urgent. DWR DMP has found integrity issues, LOF between 4 and 5. Corrosion in pipe visible at LS toe. Crossing will be monitored until funding becomes available for rehabilitation or removal. No permit was found authorizing this encroachment. CVFPB will need to review crossing to determine owner. (B. Singh - GEI, O. Magana - DWR UCIP)04/09/2014 Dense vegetation limits the inspector's visibility to identify signs of pipe failure (leaks) along the slope. Recommend removing vegetation along pipe alignment to conduct proper inspection of structure. (W. Wylie - DWR UCIP) FIELD_STRUCT_DESC: 24-inch corrugated metal gravity drainage pipe through the levee, 8 feet below the crown. Flap gate on the waterside (WS) end. Brass cap No. 80 bench mark (BM) on the headwall on the landside (LS). [Additional Reference(s): DWR Levee Log, 2002 (HLM 8.09), listed as a 24-inch corrugated metal pipe (CMP). USACE San Joaquin O&M Manual, Unit 601 Part 1 (SJR601.1), 1967, Revised 25 May 2011, (HLM 8.07), listed as a 24-inch CMP]. FS Date: 10/20/2020

Pipe, Headwall, and flapgate at WS toe.

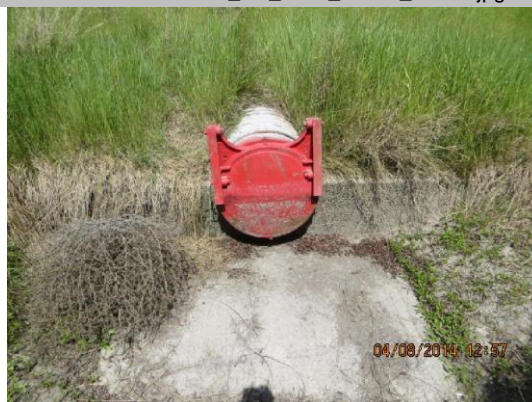
Photo 2 of 3 : UCIP\_SP\_2021\_62654\_60847.jpg

Pipe, Headwall, and flapgate at WS toe.

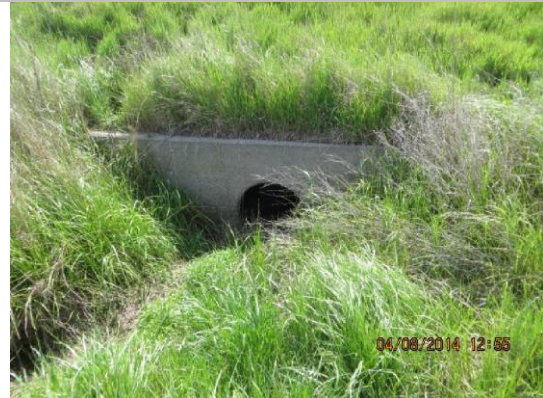
Photo 3 of 3 : UCIP\_SP\_2021\_62654\_60846.jpg

Pipe and concrete headwall on LS toe.

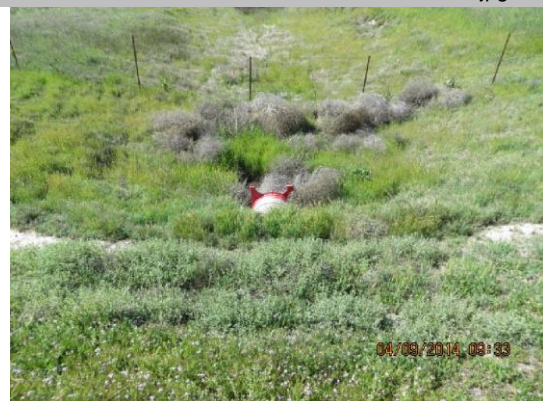
Photo 1 of 3 : UCIP\_SP\_2021\_62660\_60850.jpg

FS\_ID:62660  
DS\_ID:19621  
EP\_NO: N/A  
Repair Type: Urgent  
Crossing Status: Found  
UCIP Comments: 10/20/2020 Pipe status is Urgent. DWR DMP has found integrity issues, LOF between 4 and 5. Crossing will be monitored until funding becomes available for rehabilitation. No permit was found authorizing this encroachment. CVFPB will need to review crossing to determine owner. (B. Singh - GEI, O. Magana - DWR UCIP)04/09/2014 Dense vegetation limits the inspector's visibility to identify signs of pipe failure (leaks) along the slope. Recommend removing vegetation along pipe alignment to conduct proper inspection of structure. Sediment buildup at landward toe. (W. Wylie - DWR UCIP) FIELD\_STRUCT\_DESC: 24-inch corrugated metal gravity drainage pipe through the levee, 9.5 feet below the crown. Flap gate on the waterside (WS) end. Brass cap No. 80 bench mark (BM) on the headwall on the landside (LS). [Additional Reference(s): DWR Levee Log, 2002 (HLM 8.43), listed as a 24-inch corrugated metal pipe (CMP). USACE San Joaquin O&M Manual, Unit 601 Part 1 (SJR601.1), 1967, Revised 25 May 2011, (HLM 8.41), listed as a 24-inch CMP]. FS Date: 10/20/2020

Concrete headwall, pipe, and flapgate at WS toe.

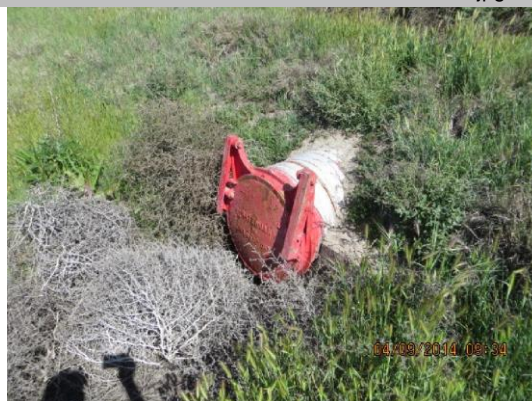
Photo 2 of 3 : UCIP\_SP\_2021\_62660\_60848.jpg

Concrete headwall, pipe, and flapgate at WS toe.

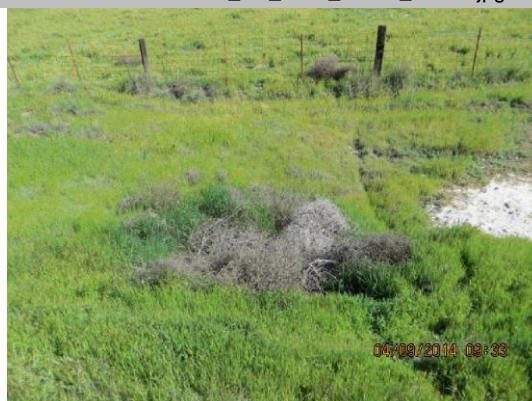
Photo 3 of 3 : UCIP\_SP\_2021\_62660\_60849.jpg

Pipe and concrete headwall at LS toe. Note heavy vegetation.

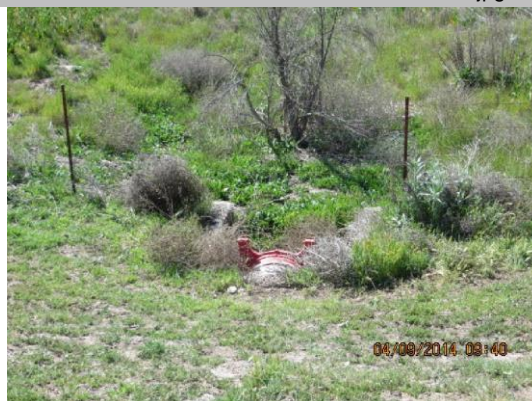
Photo 1 of 3 : UCIP\_SP\_2021\_62662\_60854.jpg

Comment Code						
Inspector Comment						
FS_ID:62662						
DS_ID:19622						
EP_NO: N/A						
Repair Type: Non-Urgent						
Crossing Status: Found						
UCIP Comments: 10/20/2020 Pipe status is Non-Urgent. Large burrow hole observed approximately 100 feet downstream of the pipe, on LS shoulder of the levee crown. No permit was found authorizing this encroachment. CVFPB will need to review crossing to determine owner. DWR DMP has not found internal issues, LOF between 1 and 2. Recommend inspection in 5 years. (B. Singh - GEI, O. Magana - DWR UCIP)						
FIELD_STRUCT_DESC: 24-inch corrugated metal gravity drainage pipe through the levee, 9 feet below the crown. Flap gate on the waterside (WS) end. Brass cap No. 80 bench mark (BM) on the headwall on the landside (LS). [Additional Reference(s): DWR Levee Log, 2002 (HLM 8.62), listed as a 24-inch corrugated metal pipe (CMP). USACE San Joaquin O&M Manual, Unit 601 Part 1 (SJR601.1), 1967, Revised 25 May 2011, (HLM 8.61), listed as a 24-inch CMP].

Pipe, Flapgate, and headwall on WS toe.

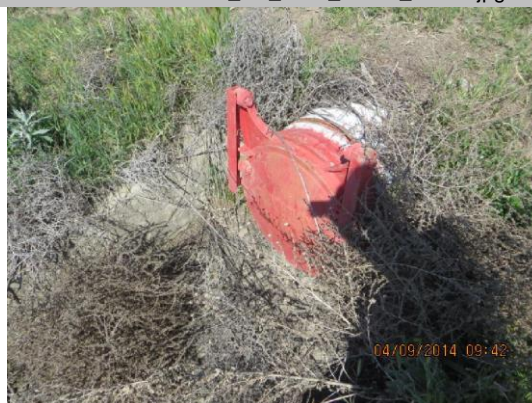
Photo 2 of 3 : UCIP\_SP\_2021\_62662\_60855.jpg

Pipe, Flapgate, and headwall on WS toe.

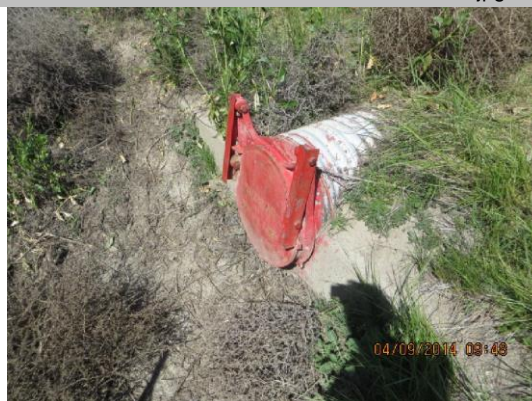
Photo 2 of 3 : UCIP\_SP\_2021\_62663\_60860.jpg

Pipe, flapgate, and headwall on WS toe.

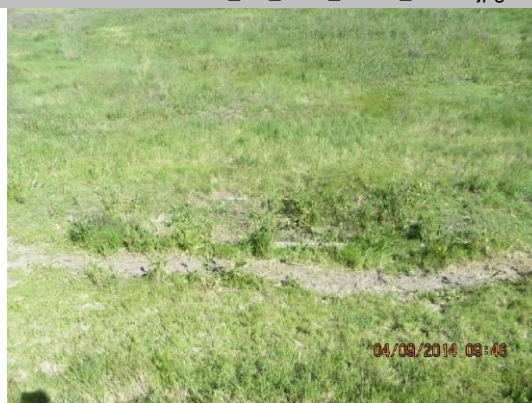
Photo 3 of 3 : UCIP\_SP\_2021\_62663\_60858.jpg

Pipe and headwall visible on LS toe.

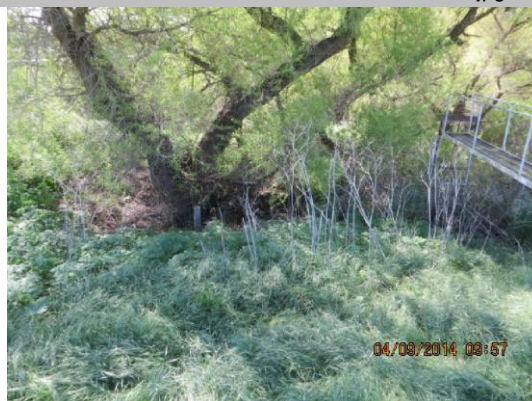
Photo 1 of 3 : UCIP\_SP\_2021\_62665\_60870.jpg

Comment Code						
Inspector Comment						
FS_ID:62665 DS_ID:19625 EP_NO: N/A Repair Type: Non-Urgent Crossing Status: Found UCIP Comments: 10/20/2020 As in previous inspection, dense vegetation inhibited proper inspection of the pipe and slope. Pipe status is still Non-Urgent. No permit was found authorizing this encroachment. CVFPB will need to review crossing to determine owner. DWR DMP has not completed an internal inspection of the pipe but is scheduled for 2021. (B. Singh - GEI, O. Magana - DWR UCIP)04/09/2014 Dense vegetation limits the inspector's visibility to identify signs of pipe failure (leaks) along the slope. Recommend removing vegetation along pipe alignment to conduct proper inspection of structure. Some sediment buildup in pipe. (W. Wylie - DWR UCIP) FIELD_STRUCT_DESC: 36-inch corrugated metal gravity drainage pipe through the levee, 10 feet below the crown. Flap gate on the waterside (WS) end. Brass cap No. 80 bench mark (BM) on the headwall on the landside (LS). [Additional Reference(s): DWR Levee Log, 2002 (HLM 9.01), listed as a 36-inch corrugated metal pipe (CMP). USACE San Joaquin O&M Manual, Unit 601 Part 1 (SJR601.1), 1967, Revised 25 May 2011, (HLM 9.00), listed as a 36-inch CMP]. FS Date: 10/20/2020

Pipe and flapgate visible on WS toe.

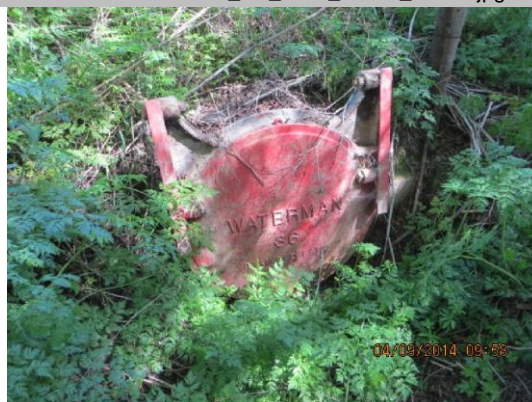
Photo 2 of 3 : UCIP\_SP\_2021\_62665\_60869.jpg

Pipe and flapgate visible on WS toe.

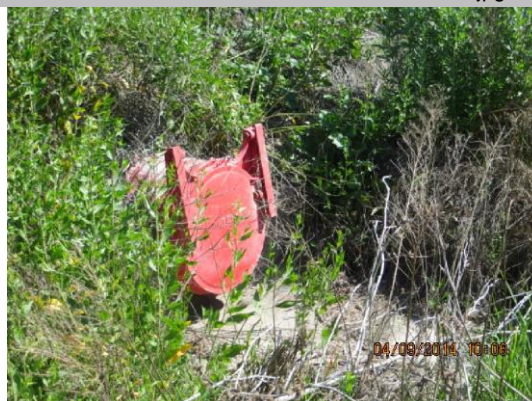
Photo 2 of 3 : UCIP\_SP\_2021\_62695\_60871.jpg

Pipe, concrete headwall, and flapgate at WS toe.

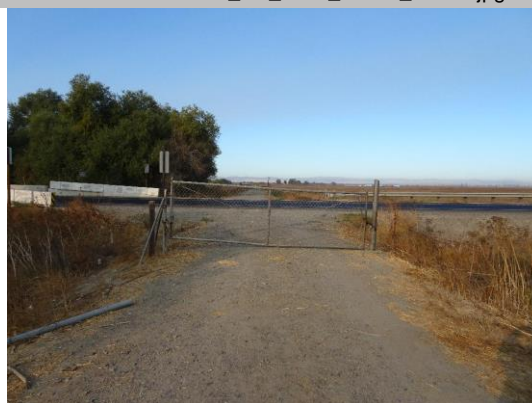
Photo 3 of 3 : UCIP\_SP\_2021\_62695\_90906.jpg

Overview of levee crown

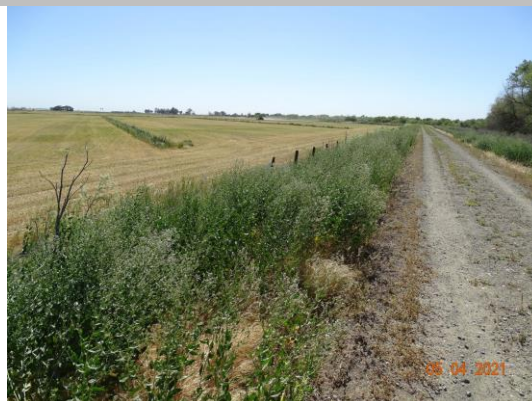
Photo 1 of 1 : SP\_2021\_NA0010\_118\_129\_20210517\_00308.jpg

View of the landside slope looking upstream. (Spring 2021)

LM Start	9.01	Rating **	U	Issue No.	129
LM End	9.62	Issue Type +	Ma	Location *	LS
Category	Earthen Levee			GPS Latitude/Longitude	
				Start	End
Item	Vegetation			37.297502 °	37.295038 °
				-120.850732 °	-120.840723 °
DWR ID	DWR_NA0010_01_s_2021_129				
Comment Code					
V1 : Control annual grass and weeds on the levee slopes and easements.					
Inspector Comment

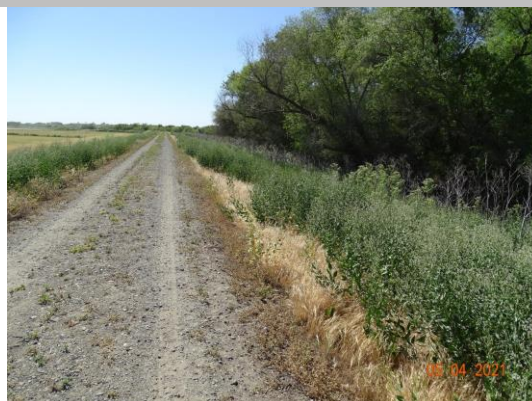
Photo 1 of 1 : SP\_2021\_NA0010\_118\_131\_20210517\_00309.jpg

Looking upstream along the waterside slope. (Spring 2021)

LM Start	9.01	Rating **	U	Issue No.	131
LM End	9.50	Issue Type +	Ma	Location *	WS
Category	Earthen Levee			GPS Latitude/Longitude	
				Start	End
Item	Vegetation			37.297502 °	37.295457 °
				-120.850731 °	-120.842752 °
DWR ID	DWR_NA0010_01_s_2021_131				
Comment Code					
V1 : Control annual grass and weeds on the levee slopes and easements.					
Inspector Comment

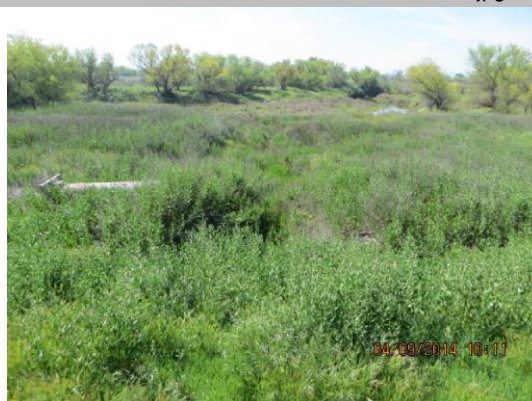
Photo 1 of 3 : UCIP\_SP\_2021\_62696\_60875.jpg

Comment Code						
Inspector Comment						
FS_ID:62696 DS_ID:19627 EP_NO: N/A Repair Type: Urgent Crossing Status: Found UCIP Comments: 10/21/2020 Pipe status is Urgent. DWR DMP has found integrity issues, LOF between 5 and 6. Scouring observed approximately 2 feet DS of pipe at WS toe. Crossing will be monitored until funding becomes available for removal. No permit was found authorizing this encroachment. CVFPB will need to review crossing to determine owner. (B. Singh - GEI, O. Magana - DWR UCIP)04/09/2014 Dense vegetation limits the inspector's visibility to identify signs of pipe failure (leaks) along the slope. Recommend removing vegetation along pipe alignment to conduct proper inspection of structure. (W. Wylie - DWR UCIP ) FIELD_STRUCT_DESC: 24-inch corrugated metal gravity drainage pipe through the levee, 8.6 feet below the crown. Concrete drop inlet at the landside (LS) toe. Flap gate on the waterside (WS) end. Brass cap No. 80 bench mark (BM) on the headwall on the LS. [Additional Reference(s): DWR Levee Log, 2002 (HLM 9.39), listed as a 24-inch corrugated metal pipe (CMP). USACE San Joaquin O&M Manual, Unit 601 Part 1 (SJR601.1), 1967, Revised 25 May 2011, (HLM 9.37), listed as 24-inch CMP]. FS Date: 10/21/2020

Pipe and flapgate on WS toe.

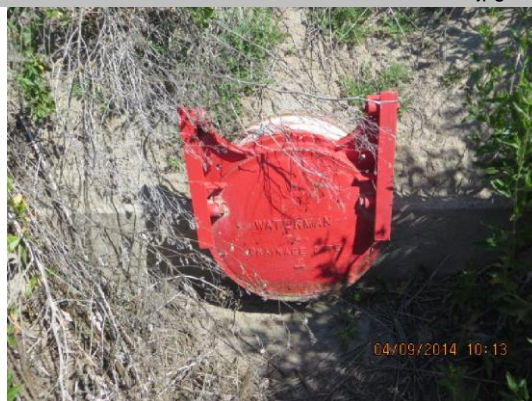
Photo 2 of 3 : UCIP\_SP\_2021\_62696\_60876.jpg

Headwall, Pipe, and flapgate on WS toe.

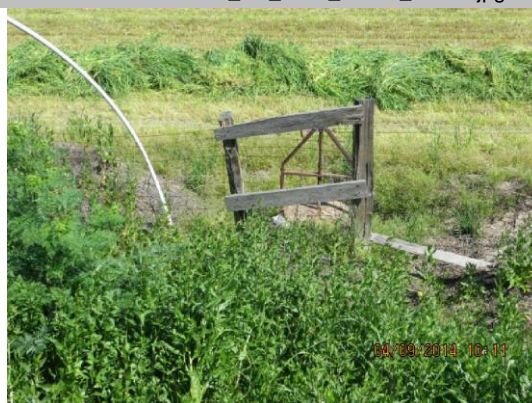
Photo 3 of 3 : UCIP\_SP\_2021\_62696\_60874.jpg

Concrete drop-inlet installed on pipe at LS toe.

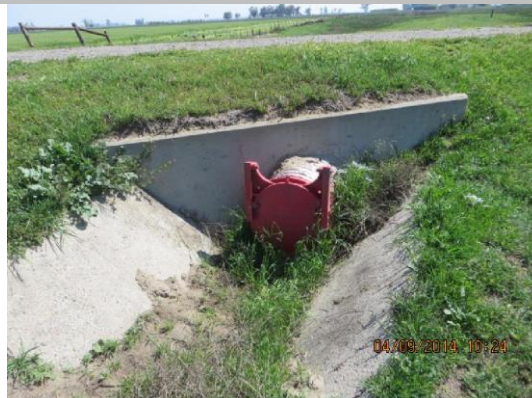
Photo 1 of 3 : UCIP\_SP\_2021\_62697\_60880.jpg

Comment Code						
Inspector Comment						
FS_ID:62697 DS_ID:19628 EP_NO: N/A Repair Type: Non-Urgent Crossing Status: Found UCIP Comments: 10/21/2020 Pipe status is still Non-Urgent. No permit was found authorizing this encroachment. CVFPB will need to review crossing to determine owner. DWR DMP has not found internal issues, LOF between 1 and 2. Recommend inspection in 5 years. (B. Singh - GEI, O. Magana - DWR UCIP) FIELD_STRUCT_DESC: 24-inch corrugated metal gravity drainage pipe through the levee, 4.5 feet below the crown. Flap gate on the waterside (WS) end. Brass cap No. 80 bench mark (BM) on the headwall on the landside (LS). [Additional Reference(s): DWR Levee Log, 2002 (HLM 9.68), listed as a 24-inch corrugated metal pipe (CMP). USACE San Joaquin O&M Manual, Unit 601 Part 1 (SJR601.1), 1967, Revised 25 May 2011, (HLM 9.67), listed as a 24-inch CMP]. FS Date: 10/21/2020

Pipe, flapgate, and headwall visible on WS toe.

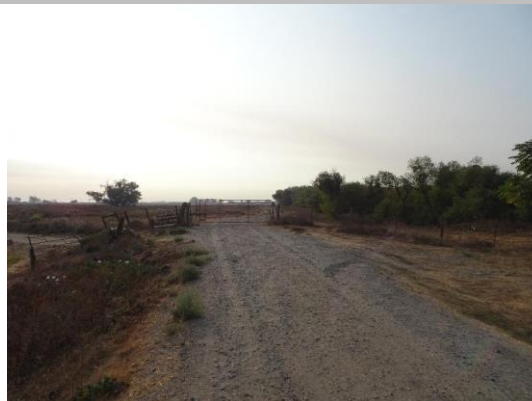
Photo 2 of 3 : UCIP\_SP\_2021\_62697\_90915.jpg

Overview of levee crown

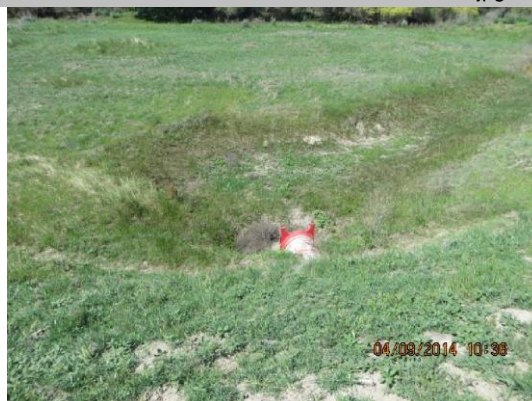
Photo 1 of 3 : UCIP\_SP\_2021\_62698\_60884.jpg

Comment Code						
Inspector Comment						
FS_ID:62698						
DS_ID:19629						
EP_NO: N/A						
Repair Type: Non-Urgent						
Crossing Status: Found						
UCIP Comments: 10/21/2020 Pipe status is still Non-Urgent. No permit was found authorizing this encroachment. CVFPB will need to review crossing to determine owner. DWR DMP has not found internal issues, LOF between 1 and 2. Recommend inspection in 5 years. (B. Singh - GEI, O. Magana - DWR UCIP)04/09/2014 Dense vegetation blocks waterward and landward toes Recommend removing vegetation from both toes. Also sediment buildup in pipe visible from landward side. (W. Wylie - UCIP DMP)						
FIELD_STRUCT_DESC: 24-inch corrugated metal gravity drainage pipe through the levee, 9 feet below the crown. Flap gate on the waterside (WS) end. Brass cap No. 69 bench mark (BM) on the headwall on the landside (LS). [Additional Reference(s): DWR Levee Log, 2002 (HLM 10.24), listed as a 24-inch corrugated metal pipe (CMP). USACE San Joaquin O&M Manual, Unit 601 Part 1 (SJR601.1), 1967, Revised 25 May 2011, (HLM 10.23), listed as a 24-inch CMP].

Pipe, headwall, and flapgate on WS toe.

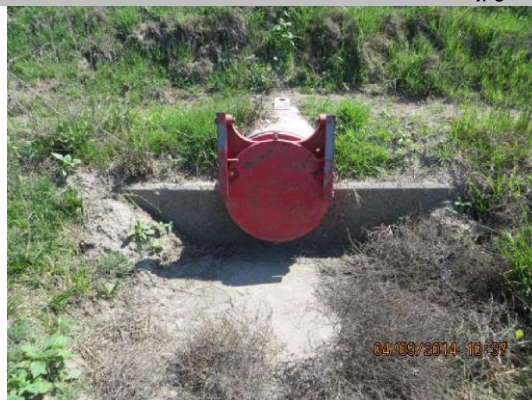
Photo 2 of 3 : UCIP\_SP\_2021\_62698\_60886.jpg

Pipe, headwall, and flapgate at WS toe.

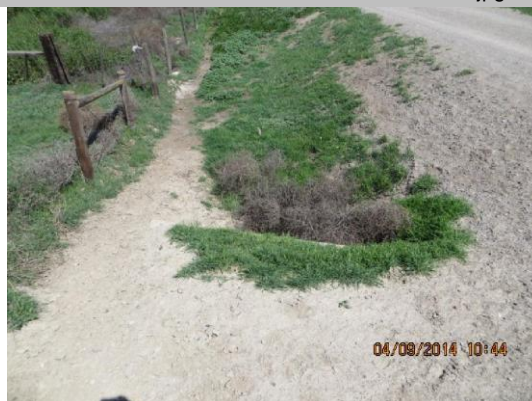
Photo 2 of 3 : UCIP\_SP\_2021\_62711\_60889.jpg

Pipe and headwall on LS toe.

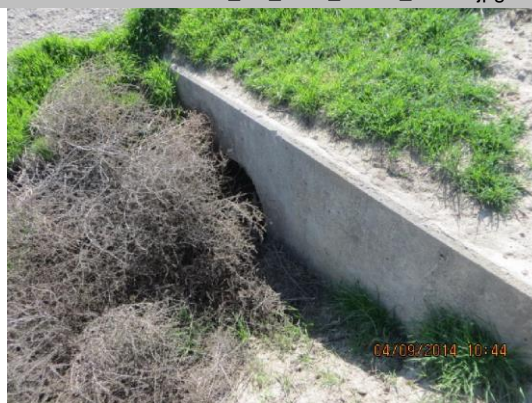
Photo 3 of 3 : UCIP\_SP\_2021\_62711\_60888.jpg

Pipe and headwall on LS toe.

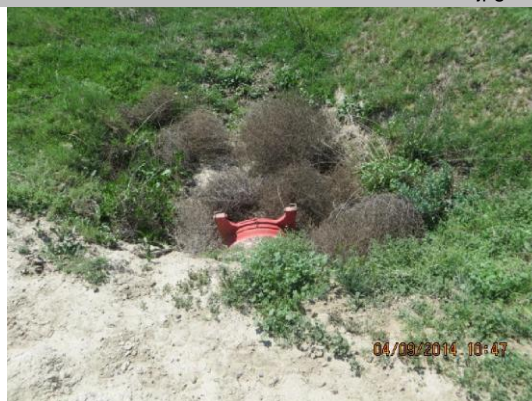
Photo 1 of 3 : UCIP\_SP\_2021\_62714\_60894.jpg

Comment Code					
Inspector Comment					
FS_ID:62714 DS_ID:19631 EP_NO: N/A Repair Type: Urgent Crossing Status: Found UCIP Comments: 10/21/2020 Pipe status is Urgent. DWR DMP has found integrity issues, LOF between 4 and 5. Crossing will be monitored until funding becomes available for rehabilitation. No permit was found authorizing this encroachment. CVFPB will need to review crossing to determine owner. (B. Singh - GEI, O. Magana - DWR UCIP) FIELD_STRUCT_DESC: 24-inch corrugated metal gravity drainage pipe through the levee, 7 feet below the crown. Flap gate on the waterside (WS) end. Brass cap No. 67 bench mark (BM) on the headwall on the landside (LS). [Additional Reference(s): DWR Levee Log, 2002 (HLM 10.74), listed as a 24-inch corrugated metal pipe (CMP). USACE San Joaquin O&M Manual, Unit 601 Part 1 (SJR601.1), 1967, Revised 25 May 2011, (HLM 10.72), listed as a 24-inch CMP]. FS Date: 10/21/2020

Headwall, pipe, and flapgate on WS toe.

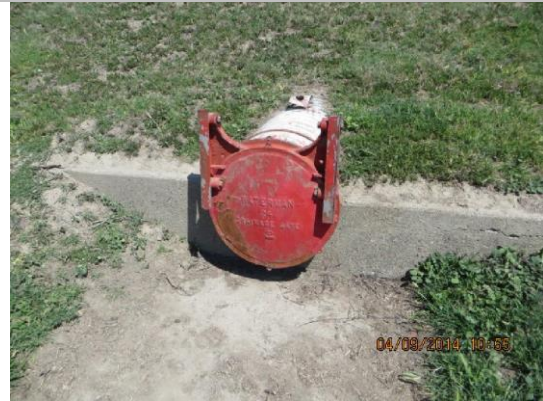
Photo 2 of 3 : UCIP\_SP\_2021\_62699\_60899.jpg

Pipe, headwall, and flapgate on WS toe.

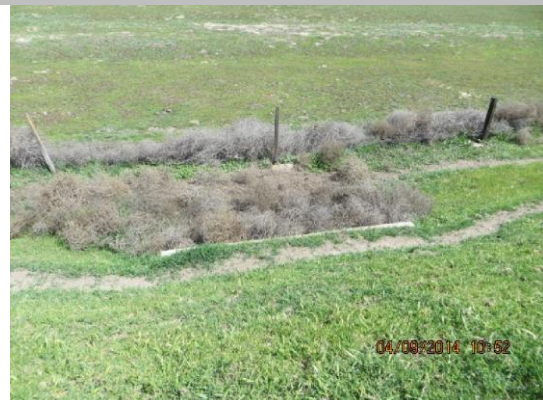
Photo 3 of 3 : UCIP\_SP\_2021\_62699\_60898.jpg

Pipe and headwall on LS toe.

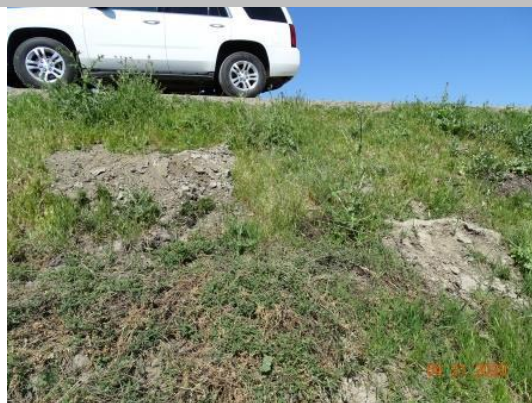
Photo 1 of 1 : SP\_2021\_NA0010\_118\_151\_20210308\_00030.jpg

Rodent burrows in the landside slope. (Spring 2020)

LM Start	11.37	Rating **	M	Issue No.	151
LM End	11.37	Issue Type +	Ma	Location *	LS
Category	Earthen Levee			GPS Latitude/Longitude	
				Start	End
Item	Animal Control			37.275481 °	37.275481 °
				-120.826042 °	-120.826042 °
DWR ID	DWR_NA0010_01_s_2020_151				
Comment Code					
A1 : Exterminate rodents and backfill and compact or grout burrows.					
Inspector Comment

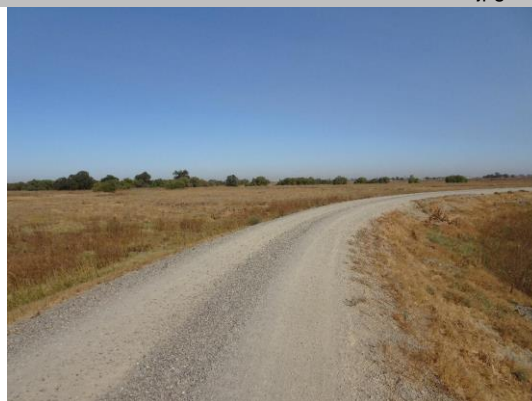
Photo 1 of 3 : UCIP\_SP\_2021\_62701\_90940.jpg

Comment Code						
Inspector Comment						
FS_ID:62701 DS_ID:19814 EP_NO: N/A Repair Type: Non-Urgent Crossing Status: Found UCIP Comments: 10/21/2020 Pipe status is still Non-Urgent. Steep slopes prevented further inspection. No permit was found authorizing this encroachment. CVFPB will need to review crossing to determine owner. DWR DMP has not found internal issues, LOF between 1 and 2. Recommend inspection in 5 years. (B. Singh - GEI, O. Magana - DWR UCIP) FIELD_STRUCT_DESC: 24-inch corrugated metal gravity drainage pipe through levee, 12 feet below the crown. Two metal cutoff walls. Flap gate on the waterside (WS) end. Concrete headwall on the landside (LS) end. Concrete saddle and apron on the WS end. [Additional Reference(s): DWR Levee Log, 2002. USACE San Joaquin O&M Manual 601.1, 1967, (recorded as U6 HLM 0.05 should be U1 HLM 11.37)]. FS Date: 10/21/2020

Overview of levee crown

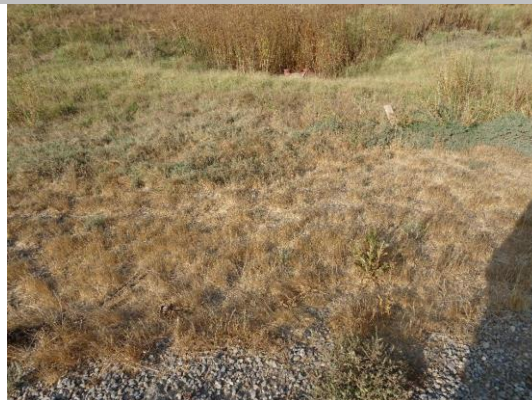
Photo 3 of 3 : UCIP\_SP\_2021\_62701\_90942.jpg

View waterward. Pipe and flapgate visible

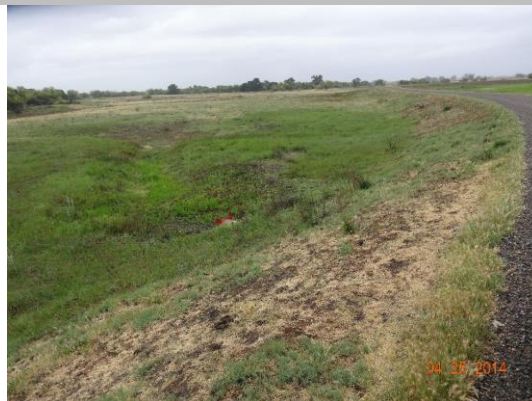
Photo 1 of 3 : UCIP\_SP\_2021\_62702\_65362.jpg

FS\_ID:62702  
DS\_ID:19634  
EP\_NO: N/A  
Repair Type: Urgent  
Crossing Status: Found  
UCIP Comments: 10/21/2020 Pipe status is Urgent. DWR DMP has found integrity issues, LOF between 4 and 5. Dense vegetation inhibited inspection of pipe and headwall at LS toe; Pipe not found at LS toe. Crossing will be monitored until funding becomes available for rehabilitation. No permit was found authorizing this encroachment. CVFPB will need to review crossing to determine owner. (B. Singh - GEI, O. Magana - DWR UCIP)04/25/2014 Need to contact owner--landward side has been buried. It appears that soil was removed from levee toe, immediately upstream, and used to pile soil at landward side at crossing. (O. Magana - DWR UCIP)  
FIELD\_STRUCT\_DESC: 24-inch corrugated metal gravity drainage pipe through the levee, 10 feet below the crown. Flap gate on the waterside (WS) end. Brass cap No. 62 bench mark (BM) on the headwall on the landside (LS). [Additional Reference(s): DWR Levee Log, 2002 (HLM 11.48), listed as a 24-inch corrugated metal pipe (CMP). USACE San Joaquin O&M Manual, Unit 601 Part 1 (SJR601.1), 1967, Revised 25 May 2011, (HLM 11.48), listed as a 24-inch CMP].

View of waterward side.

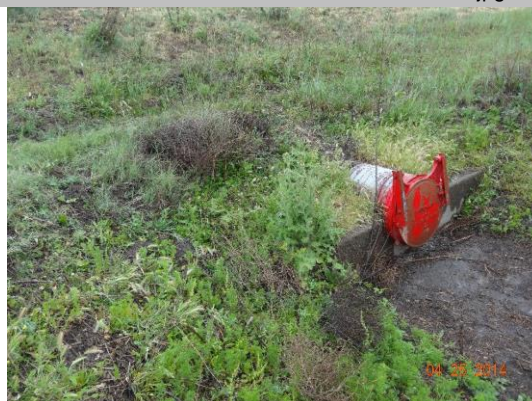
Photo 2 of 3 : UCIP\_SP\_2021\_62702\_65364.jpg

View of concrete headwall and flap gate visible on waterward side.

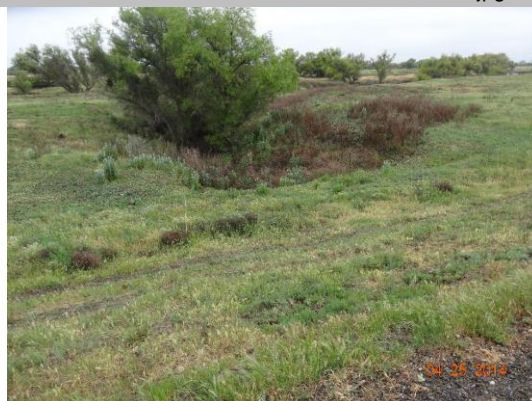
Photo 1 of 3 : UCIP\_SP\_2021\_62703\_65372.jpg

Comment Code						
Inspector Comment						
FS_ID:62703 DS_ID:19635 EP_NO: N/A Repair Type: Non-Urgent Crossing Status: Found UCIP Comments: 10/21/2020 Pipe status is still Non-Urgent. Geophysics study found evidence of pipe at coordinates 2272708.537, 13540017.857. Pipe and flapgate buried by dry vegetation at WS toe and pipe and headwall blocked by debris at LS toe, inhibiting proper inspection. Recommend removal of excess vegetation. No permit was found authorizing this encroachment. CVFPB will need to review crossing to determine owner. DWR DMP has not completed an internal inspection of the pipe but is scheduled for 2021. (B. Singh - GEI, O. Magana - DWR UCIP)04/25/2014 Crossing is non-functional -- landward side is buried. Debris found on landward side (channel). Dense vegetation found on waterward slope. Recommend contacting owner to determine status of crossing. If crossing is no longer used need to coordinate with CVFPB for proper abandonment. (O. Magana - DWR UCIP) FIELD_STRUCT_DESC: 24-inch corrugated metal gravity drainage pipe through the levee, 17 feet below the crown. Flap gate on the waterside (WS) end. Brass cap No. 61 bench mark (BM) on the headwall on the landside (LS). [Additional Reference(s): DWR Levee Log, 2002 (HLM 11.77), listed as a 24-inch corrugated metal pipe (CMP). USACE San Joaquin O&M Manual, Unit 601 Part 1 (SJR601.1), 1967, Revised 25 May 2011, (HLM 11.76), listed as a 24-inch CMP]. FS Date: 10/21/2020

View of waterward side.

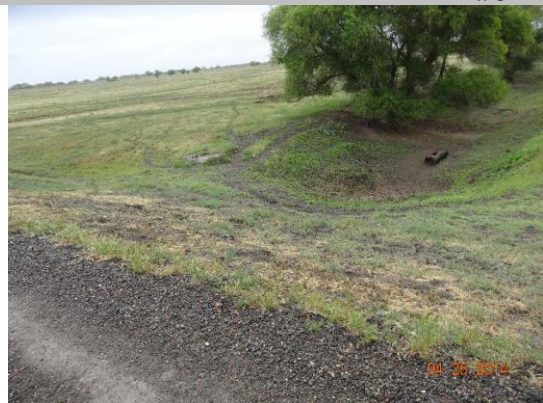
Photo 3 of 3 : UCIP\_SP\_2021\_62703\_65373.jpg

Landward side of crossing buried--damage pipe section visible on landward side.

View of landward side.

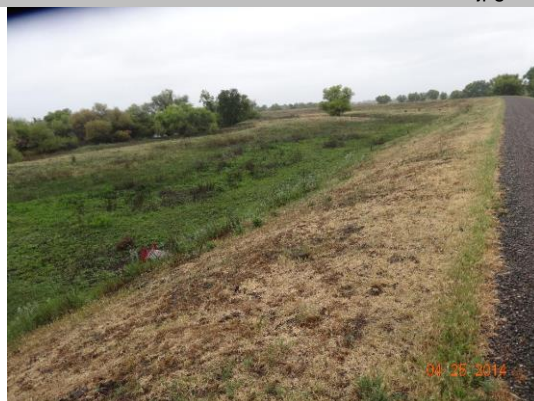
Photo 1 of 3 : UCIP\_SP\_2021\_62704\_65378.jpg

Comment Code						
Inspector Comment						
FS_ID:62704 DS_ID:19636 EP_NO: N/A Repair Type: Non-Urgent Crossing Status: Found UCIP Comments: 10/21/2020 Dense vegetation inhibited proper inspection of pipe at LS and WS toes. Pipe status is still Non-Urgent. No permit was found authorizing this encroachment. CVFPB will need to review crossing to determine owner. DWR DMP has not completed an internal inspection of the pipe but is scheduled for 2021. (B. Singh - GEI, O. Magana - DWR UCIP)04/25/2014 Crossing is non-functional --landward side is buried. Dense vegetation found on waterward slope. Recommend contacting owner to determine status of crossing. If crossing is no longer used need to coordinate with CVFPB for proper abandonment. (O. Magana - DWR UCIP) FIELD_STRUCT_DESC: 24-inch corrugated metal gravity drainage pipe through the levee, 12.4 feet below the crown. Flap gate on the waterside (WS) end. Brass cap No. 60 bench mark (BM) on the headwall on the landside (LS). [Additional Reference(s): DWR Levee Log, 2002 (HLM 12.12), listed as a 24-inch corrugated metal pipe (CMP). USACE San Joaquin O&M Manual, Unit 601 Part 1 (SJR601.1), 1967, Revised 25 May 2011, (HLM 12.11), listed as a 24-inch CMP]. FS Date: 10/21/2020

View of waterward side--flap gate visible on waterward toe.

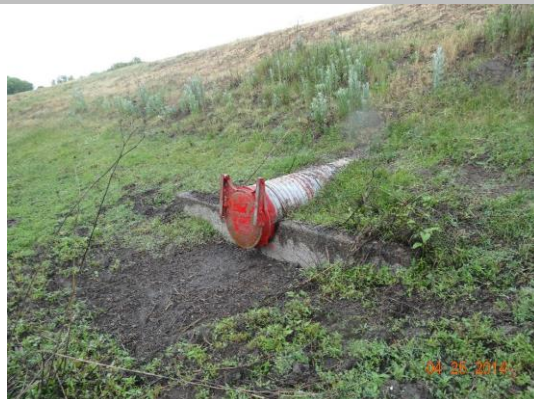
Photo 2 of 3 : UCIP\_SP\_2021\_62704\_65379.jpg

Flap gate and concrete headwall visible on waterward side.

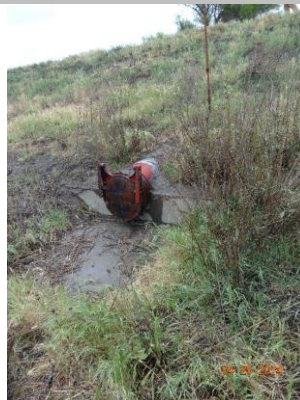
Photo 2 of 3 : UCIP\_SP\_2021\_62705\_65411.jpg

Flap gate and concrete headwall visible on waterward side.

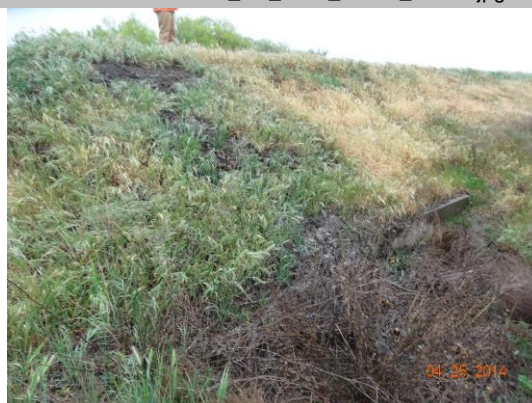
Photo 3 of 3 : UCIP\_SP\_2021\_62705\_65410.jpg

View of landward side--concrete headwall visible covered by dense vegetation.

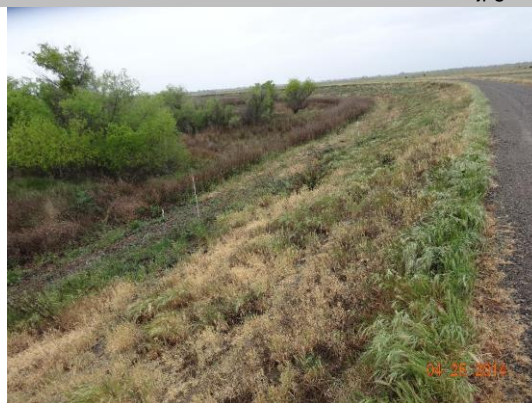
Photo 1 of 3 : UCIP\_SP\_2021\_62706\_65389.jpg

Comment Code					
Inspector Comment					
FS_ID:62706 DS_ID:19638 EP_NO: N/A Repair Type: Non-Urgent Crossing Status: Found UCIP Comments: 10/21/2020 Pipe status is still Non-Urgent. No permit was found authorizing this encroachment. CVFPB will need to review crossing to determine owner. DWR DMP has not completed an internal inspection of the pipe but is scheduled for 2021. (B. Singh - GEI, O. Magana - DWR UCIP)04/25/2014 Dense vegetation limits the inspector's visibility to identify signs of pipe failure (leaks) along the landward slope. Concrete headwall blocked by debris located on landward toe. Recommend clearing debris from landward slope and toe. (O. Magana - DWR UCIP) FIELD_STRUCT_DESC: 24-inch corrugated metal gravity drainage pipe through the levee, 14.2 feet below the crown. Flap gate on the waterside (WS) end. Brass cap No. 60 bench mark (BM) on the headwall on the landside (LS). [Additional Reference(s): DWR Levee Log, 2002 (HLM 13.48), listed as a 24-inch corrugated metal pipe (CMP). USACE San Joaquin O&M Manual, Unit 601 Part 1 (SJR601.1), 1967, Revised 25 May 2011, (HLM 13.48), listed as a 24-inch CMP]. FS Date: 10/21/2020

View of waterward side.

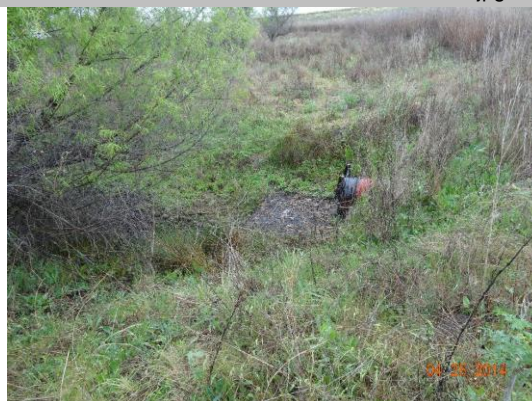
Photo 2 of 3 : UCIP\_SP\_2021\_62706\_65387.jpg

View of flap gate and pipe through levee on waterward side.

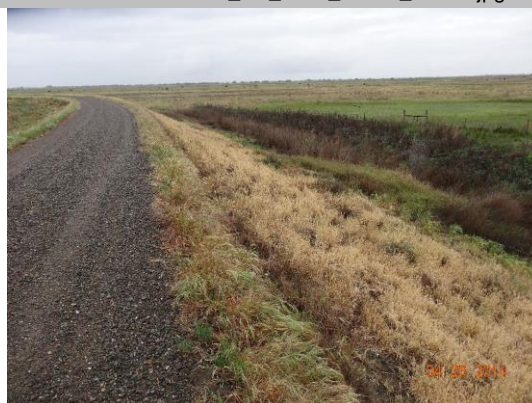
Photo 3 of 3 : UCIP\_SP\_2021\_62706\_65388.jpg

View of landward side.

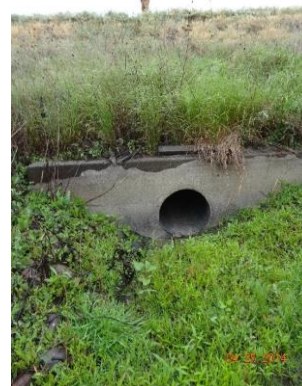
Photo 3 of 3 : UCIP\_SP\_2021\_62707\_65416.jpg

FS\_ID:62707  
DS\_ID:19639  
EP\_NO: N/A  
Repair Type: Non-Urgent  
Crossing Status: Found  
UCIP Comments: 10/21/2020 Pipe status is still Non-Urgent. No permit was found authorizing this encroachment. CVFPB will need to review crossing to determine owner. DWR DMP has not completed an internal inspection of the pipe but is scheduled for 2021. (B. Singh - GEI, O. Magana - DWR UCIP)04/25/2014 No access to waterward toe due to fence. Unable to find the concrete headwall and flap gate on waterward side past fence. Also dense vegetation limits the inspector's visibility to identify signs of pipe failure (leaks) along the waterward slope. Recommend removing vegetation along pipe alignment to conduct proper inspection of structure. Also need access past fence on waterward side. (O. Magana - DWR UCIP)  
FIELD\_STRUCT\_DESC: 24-inch corrugated metal gravity drainage pipe through the levee, 14.5 feet below the crown. Flap gate on the waterside (WS) end. Brass cap No. 60 bench mark (BM) on the headwall on the landside (LS). [Additional Reference(s): DWR Levee Log, 2002 (HLM 13.58), listed as a 24-inch corrugated metal pipe (CMP). USACE San Joaquin O&M Manual, Unit 601 Part 1 (SJR601.1), 1967, Revised 25 May 2011, (HLM 13.58), listed as a 24-inch CMP].

Concrete headwall visible from landward side.

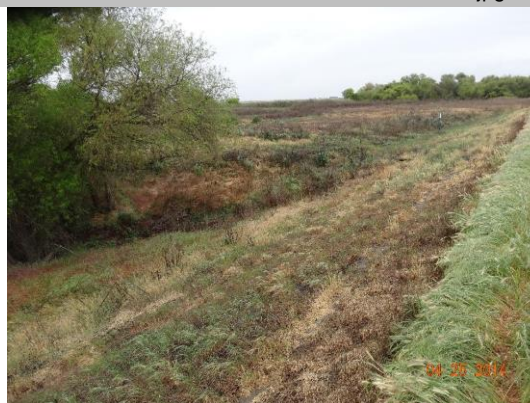
Photo 1 of 3 : UCIP\_SP\_2021\_62709\_65449.jpg

FS\_ID:62709  
DS\_ID:19641  
EP\_NO: N/A  
Repair Type: Non-Urgent  
Crossing Status: Found  
UCIP Comments: 10/21/2020 Dense vegetation at LS and WS toes inhibited proper inspection. Pipe status is still Non-Urgent. No permit was found authorizing this encroachment. CVFPB will need to review crossing to determine owner. DWR DMP has not found internal issues, LOF between 1 and 2. Recommend inspection in 5 years. (B. Singh - GEI, O. Magana - DWR UCIP)04/25/2014 Dense vegetation limits the inspector's visibility to identify signs of pipe failure (leaks) along the slopes. Recommend removing vegetation along pipe alignment to conduct proper inspection of structure. (O. Magana - DWR UCIP) FIELD\_STRUCT\_DESC: 24-inch corrugated metal gravity drainage pipe through the levee, 13 feet below the crown. Flap gate on the waterside (WS) end. Brass cap No. 60 bench mark (BM) on the headwall on the landside (LS). [Additional Reference(s): DWR Levee Log, 2002 (HLM 14.22), listed as a 24-inch corrugated metal pipe (CMP). USACE San Joaquin O&M Manual, Unit 601 Part 1 (SJR601.1), 1967, Revised 25 May 2011, (HLM 14.21), listed as a 24-inch CMP]. FS Date: 10/21/2020

View of waterward side.

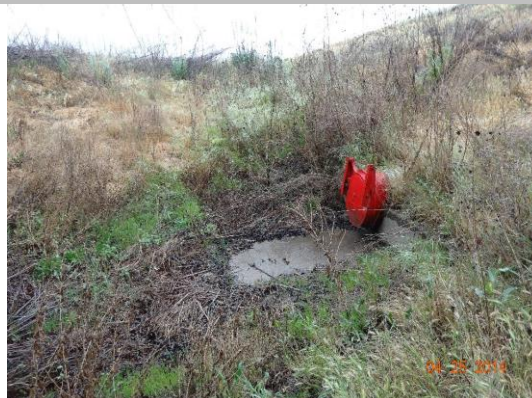
Photo 2 of 3 : UCIP\_SP\_2021\_62709\_65452.jpg

View of concrete headwall, concrete apron, and flap gate on waterward side.

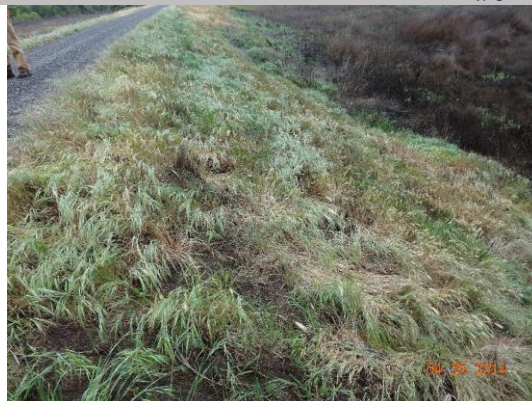
Photo 3 of 3 : UCIP\_SP\_2021\_62709\_65448.jpg

View of landward side.

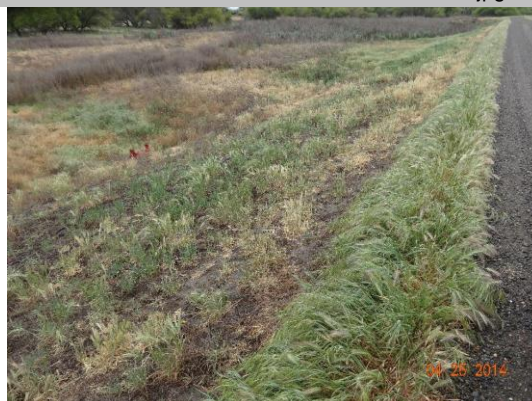
Photo 1 of 3 : UCIP\_SP\_2021\_62710\_65455.jpg

Comment Code					
Inspector Comment					
FS_ID:62710 DS_ID:19642 EP_NO: N/A Repair Type: Non-Urgent Crossing Status: Found UCIP Comments: 10/21/2020 Pipe status is still Non-Urgent. No permit was found authorizing this encroachment. CVFPB will need to review crossing to determine owner. DWR DMP has not found internal issues, LOF between 1 and 2. Recommend inspection in 5 years. (B. Singh - GEI, O. Magana - DWR UCIP)04/25/2014 Dense vegetation limits the inspector's visibility to identify signs of pipe failure (leaks) along the landward slope and toe. Recommend removing vegetation along pipe alignment to conduct proper inspection of structure. (O. Magana - DWR UCIP) FIELD_STRUCT_DESC: 24-inch corrugated metal gravity drainage pipe through the levee, 9.7 feet below the crown. Flap gate on the waterside (WS) end. Brass cap No. 60 bench mark (BM) on the headwall on the landside (LS). [Additional Reference(s): DWR Levee Log, 2002 (HLM 14.65), listed as a 24-inch corrugated metal pipe (CMP). USACE San Joaquin O&M Manual, Unit 601 Part 1 (SJR601.1), 1967, Revised 25 May 2011, (HLM 14.65), listed as a 24-inch CMP]. FS Date: 10/21/2020

View of waterward side.

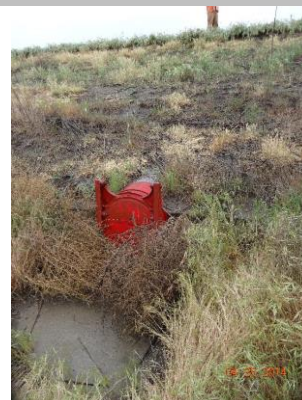
Photo 2 of 3 : UCIP\_SP\_2021\_62710\_65454.jpg

Flap gate, concrete headwall, and concrete apron located on waterward toe.

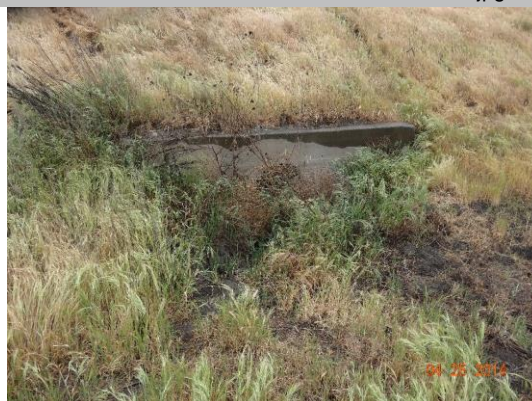
Photo 3 of 3 : UCIP\_SP\_2021\_62710\_65453.jpg

Concrete headwall located on landward toe.

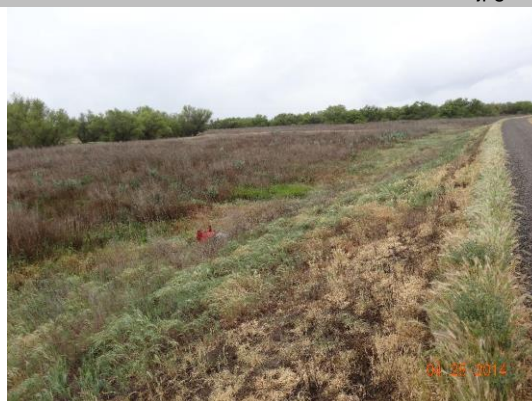
Photo 1 of 3 : UCIP\_SP\_2021\_62672\_65459.jpg

FS\_ID:62672  
DS\_ID:19643  
EP\_NO: N/A  
Repair Type: Non-Urgent  
Crossing Status: Found  
UCIP Comments: 11/16/2020 Pipe status is still Non-Urgent. Dense vegetation on LS toe limiting inhibited inspection of pipe. Significant burrowing observed on LS and WS slopes. Recommend vegetation removal and rodent mitigation. No permit was found authorizing this encroachment. CVFPB will need to review crossing to determine owner. DWR DMP has not found internal issues, LOF between 1 and 2. Recommend inspection in 5 years. (B. Singh - GEI, O. Magana - DWR UCIP)04/25/2014 Dense vegetation limits the inspector's visibility to identify signs of pipe failure (leaks) along the landward slope. Recommend removing vegetation along pipe alignment to conduct proper inspection of structure. (O. Magana - DWR UCIP)  
FIELD\_STRUCT\_DESC: 24-inch corrugated metal gravity drainage pipe through the levee, 9.2 feet below the crown. Flap gate on the waterside (WS) end. Brass cap No. 60 bench mark (BM) on the headwall on the landside (LS). [Additional Reference(s): DWR Levee Log, 2002 (HLM 15.31), listed as a 24-inch corrugated metal pipe (CMP). USACE San Joaquin O&M Manual, Unit 601 Part 1 (SJR601.1), 1967, Revised 25 May 2011, (HLM 15.29), listed as a 24-inch CMP].

View of waterward side.

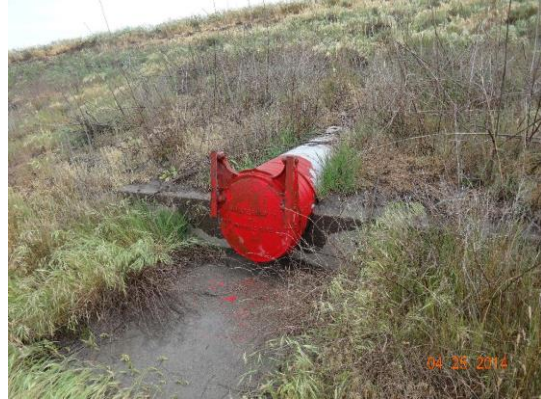
Photo 2 of 3 : UCIP\_SP\_2021\_62672\_65457.jpg

Concrete headwall, flap gate, and concrete apron located on waterward side.

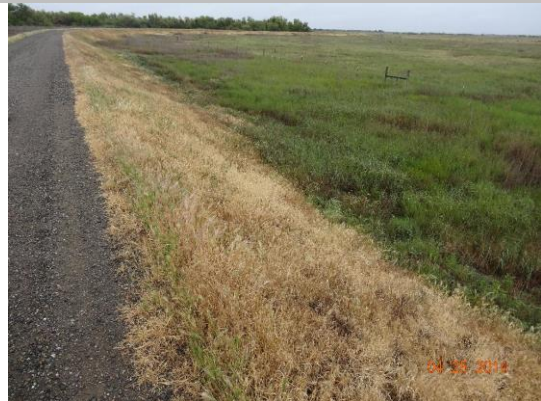
Photo 3 of 3 : UCIP\_SP\_2021\_62672\_65458.jpg

View of landward side.

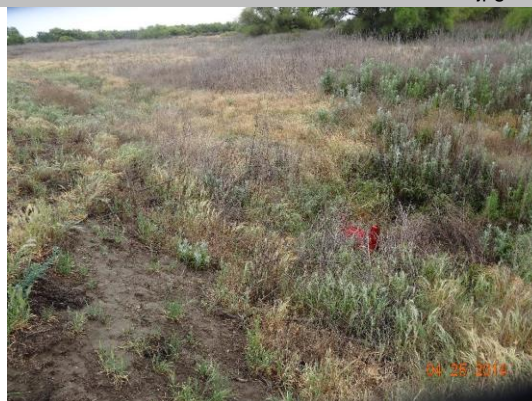
Photo 1 of 3 : UCIP\_SP\_2021\_62673\_65464.jpg

Comment Code						
Inspector Comment						
FS_ID:62673 DS_ID:19644 EP_NO: N/A Repair Type: Non-Urgent Crossing Status: Found UCIP Comments: 11/16/2020 Pipe status is still Non-Urgent. Dense vegetation on LS toe and slope inhibited proper inspection of pipe. No permit was found authorizing this encroachment. CVFPB will need to review crossing to determine owner. DWR DMP has not found internal issues, LOF between 1 and 2.04/25/2014 Dense vegetation limits the inspector's visibility to identify signs of pipe failure (leaks) along the waterward and landward slopes. Recommend removing vegetation along pipe alignment to conduct proper inspection of structure. (O. Magana - DWR UCIP) FIELD_STRUCT_DESC: 24-inch corrugated metal gravity drainage pipe through the levee, 8.5 feet below the crown. Flap gate on the waterside (WS) end. Brass cap No. 60 bench mark (BM) on the headwall on the landside (LS). [Additional Reference(s): DWR Levee Log, 2002 (HLM 15.57), listed as a 24-inch corrugated metal pipe (CMP). USACE San Joaquin O&M Manual, Unit 601 Part 1 (SJR601.1), 1967, Revised 25 May 2011, (HLM 15.57), listed as a 24-inch CMP]. FS Date: 11/16/2020

View of waterward side--flap gate visible through dense vegetation.

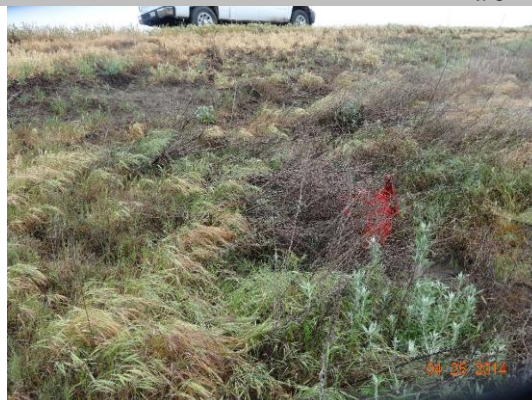
Photo 2 of 3 : UCIP\_SP\_2021\_62673\_65463.jpg

View of waterward slope covered by dense vegetation.
