**Flood Control Project Maintenance  
Levee Inspections**

## Maintenance Issue Types Only, Levee Inspection Report By Mile - Spring 2021

### Lower San Joaquin Levee District

Waterway	Bank	Unit Miles	Inspection Start/End	Inspector
Unit No. 01 San Joaquin River	Right	22.52	05/04/2021 05/04/2021	Corey Fujitani

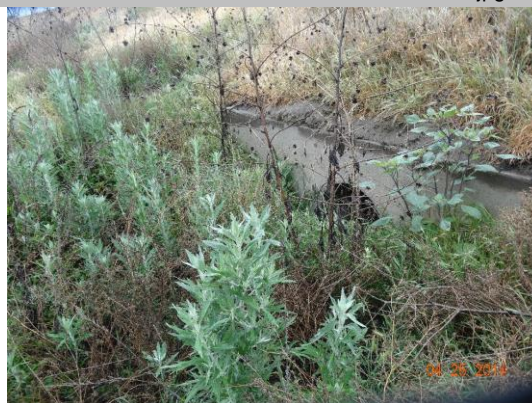
Photo 3 of 3 : UCIP\_SP\_2021\_62673\_65462.jpg

Comment Code						
Inspector Comment						
FS_ID:62673 DS_ID:19644 EP_NO: N/A Repair Type: Non-Urgent Crossing Status: Found UCIP Comments: 11/16/2020 Pipe status is still Non-Urgent. Dense vegetation on LS toe and slope inhibited proper inspection of pipe. No permit was found authorizing this encroachment. CVFPB will need to review crossing to determine owner. DWR DMP has not found internal issues, LOF between 1 and 2.04/25/2014 Dense vegetation limits the inspector's visibility to identify signs of pipe failure (leaks) along the waterward and landward slopes. Recommend removing vegetation along pipe alignment to conduct proper inspection of structure. (O. Magana - DWR UCIP) FIELD_STRUCT_DESC: 24-inch corrugated metal gravity drainage pipe through the levee, 8.5 feet below the crown. Flap gate on the waterside (WS) end. Brass cap No. 60 bench mark (BM) on the headwall on the landside (LS). [Additional Reference(s): DWR Levee Log, 2002 (HLM 15.57), listed as a 24-inch corrugated metal pipe (CMP). USACE San Joaquin O&M Manual, Unit 601 Part 1 (SJR601.1), 1967, Revised 25 May 2011, (HLM 15.57), listed as a 24-inch CMP]. FS Date: 11/16/2020

Concrete headwall visible on landward toe--dense vegetation blocking inlet.

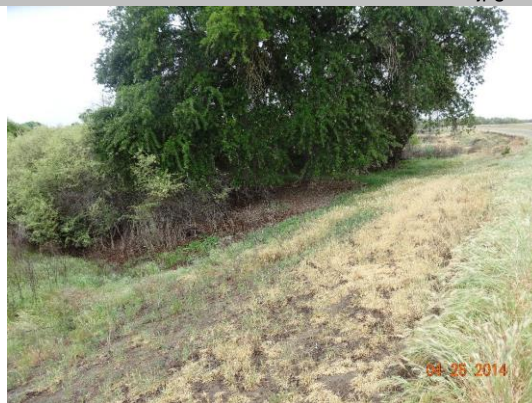
Photo 1 of 3 : UCIP\_SP\_2021\_62674\_65471.jpg

View of waterward side.

Comment Code					
Inspector Comment					
FS_ID:62674 DS_ID:19645 EP_NO: N/A Repair Type: Non-Urgent Crossing Status: Found UCIP Comments: 11/16/2020 Pipe status is still Non-Urgent, however corrosion observed in pipe inlet at LS toe. Some burrowing activity on both LS and WS slope. No permit was found authorizing this encroachment. CVFPB will need to review crossing to determine owner. DWR DMP has not completed an internal inspection of the pipe but is scheduled for 2021. (B. Singh - GEI, O. Magana - DWR UCIP)04/25/2014 Dense vegetation limits the inspector's visibility to identify signs of pipe failure (leaks) along the waterward and landward slope. Recommend removing vegetation along pipe alignment to conduct proper inspection of structure. (O. Magana - DWR UCIP) FIELD_STRUCT_DESC: 24-inch corrugated metal gravity drainage pipe through the levee, 11 feet below the crown. Flap gate on the waterside (WS) end. Brass cap No. 60 bench mark (BM) on the headwall on the landside (LS). [Additional Reference(s): DWR Levee Log, 2002 (HLM 15.82), listed as a 24-inch corrugated metal pipe (CMP). USACE San Joaquin O&M Manual, Unit 601 Part 1 (SJR601.1), 1967, Revised 25 May 2011, (HLM 15.81), listed as a 24-inch CMP]. FS Date: 11/16/2020

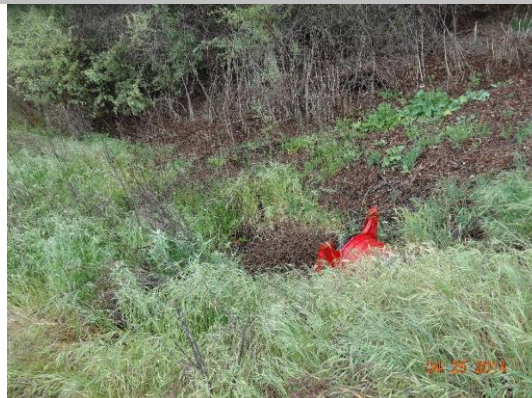
Photo 2 of 3 : UCIP\_SP\_2021\_62674\_65470.jpg

Flap gate visible on waterward side.

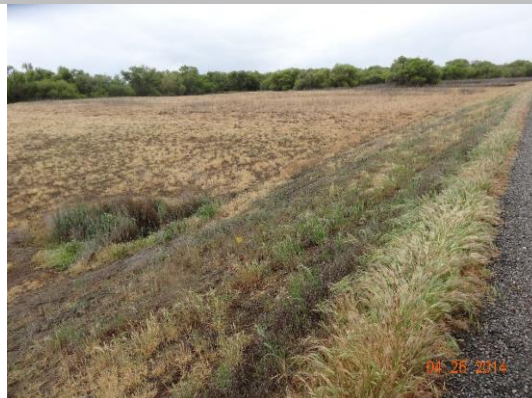
Photo 1 of 3 : UCIP\_SP\_2021\_62675\_65476.jpg

FS\_ID:62675  
DS\_ID:19646  
EP\_NO: N/A  
Repair Type: Urgent  
Crossing Status: Found  
UCIP Comments: 11/16/2020 Pipe status is Urgent. DWR DMP has found integrity issues, LOF between 5 and 6. Crossing will be monitored until funding becomes available for removal. Burrowing activity observed on LS and WS slopes. No permit was found authorizing this encroachment. CVFPB will need to review crossing to determine owner. (B. Singh - GEI, O. Magana - DWR UCIP)04/25/2014 Dense vegetation limits the inspector's visibility to identify signs of pipe failure (leaks) along the waterward and landward slopes. Recommend removing vegetation along pipe alignment to conduct proper inspection of structure and appurtenances. (O. Magana - DWR UCIP)  
FIELD\_STRUCT\_DESC: 24-inch corrugated metal gravity drainage pipe through the levee, 11.3 feet below the crown. Flap gate on the waterside (WS) end. Brass cap No. 50 bench mark (BM) on the headwall on the landside (LS). [Additional Reference(s): DWR Levee Log, 2002 (HLM 16.09), listed as a 24-inch corrugated metal pipe (CMP). USACE San Joaquin O&M Manual, Unit 601 Part 1 (SJR601.1), 1967, Revised 25 May 2011, (HLM 16.09), listed as a 24-inch pipe].

View of waterward side.

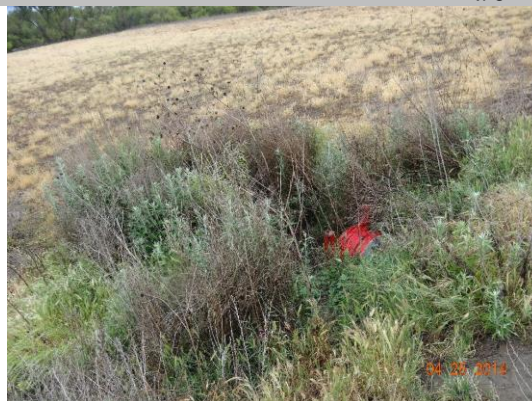
Photo 2 of 3 : UCIP\_SP\_2021\_62675\_65475.jpg

Flap gate visible on waterward toe.

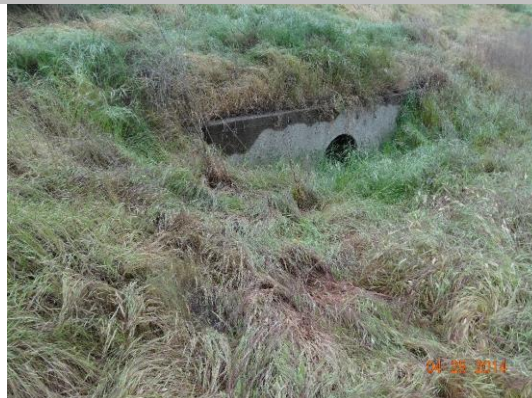
Photo 3 of 3 : UCIP\_SP\_2021\_62675\_65474.jpg

View of landward side.

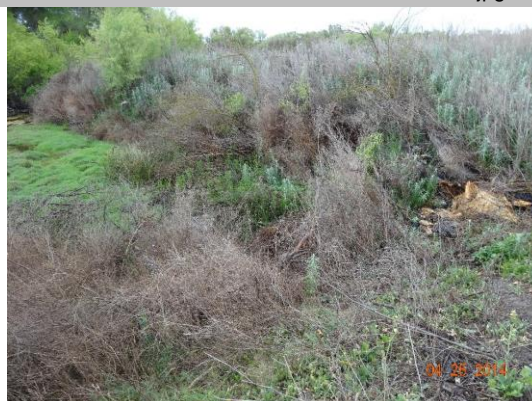
Photo 1 of 3 : UCIP\_SP\_2021\_62671\_65480.jpg

FS\_ID:62671  
DS\_ID:19647  
EP\_NO: N/A  
Repair Type: Non-Urgent  
Crossing Status: Found  
UCIP Comments: 11/16/2020 DMP record missing, need to verify if pipe inspections have been completed. Pipe and flapgate on WS toe were under water and there is dense vegetation on the LS slope and toe, inhibiting inspection. Records indicate the pipe was cleaned and inspected in Q2 2020 but is missing from updated maps. Pipe status is still Non-Urgent. No permit was found authorizing this encroachment. CVFPB will need to review crossing to determine owner. (B. Singh - GEI, O. Magana - DWR UCIP)04/25/2014 Dense vegetation limits the inspector's visibility to identify signs of pipe failure (leaks) along the waterward and landward slopes. Recommend removing vegetation along pipe alignment to conduct proper inspection of structure. Unable to find pipe on landward side. (O. Magana - DWR UCIP)  
FIELD\_STRUCT\_DESC: 24-inch corrugated metal gravity drainage pipe through the levee, 14.7 feet below the crown. Flap gate on the waterside (WS) end. Brass cap No. 50 bench mark (BM) on the headwall on the landside (LS). [Additional Reference(s): DWR Levee Log, 2002 (HLM 16.16), listed as a 24-inch corrugated metal pipe (CMP). USACE San Joaquin O&M Manual, Unit 601 Part 1 (SJR601.1), 1967, Revised 25 May 2011, (HLM 16.15), listed as a 24-inch pipe].

View of waterward side.

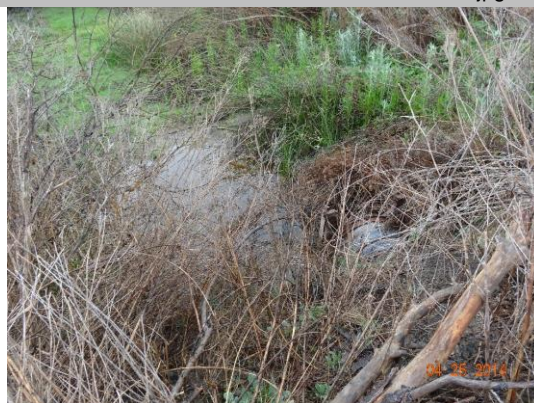
Photo 2 of 3 : UCIP\_SP\_2021\_62671\_65479.jpg

Crossing visible on waterward side under dense vegetation.

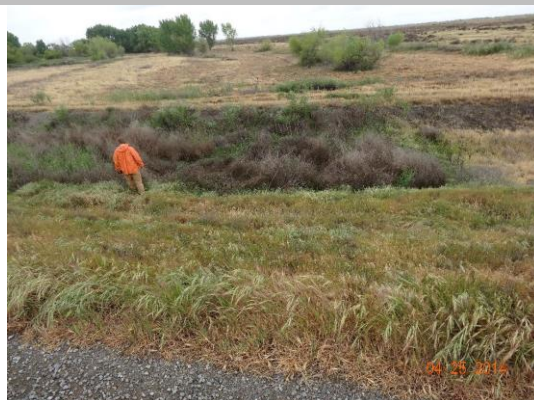
Photo 3 of 3 : UCIP\_SP\_2021\_62671\_65478.jpg

View of landward side.

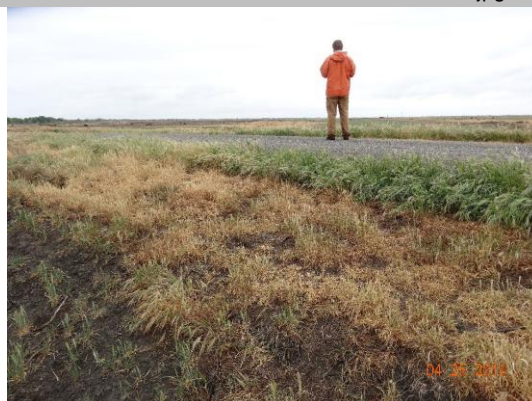
Photo 1 of 3 : UCIP\_SP\_2021\_62677\_66288.jpg

FS\_ID:62677  
DS\_ID:19648  
EP\_NO: N/A  
Repair Type: Non-Urgent  
Crossing Status: Found  
UCIP Comments: 11/16/2020 Pipe was not found at both LS and WS toes, possibly due to the dense vegetation. Recommend vegetation removal for proper inspections. DWR DMP has not completed an internal inspection of the pipe but is scheduled for 2021. No permit was found authorizing this encroachment. CVFPB will need to review crossing to determine owner. (B. Singh - GEI, O. Magana - DWR UCIP)04/25/2014 Dense vegetation limits the inspector's visibility to identify signs of pipe failure (leaks) along the waterward and landward slopes. Recommend removing vegetation along pipe alignment to conduct proper inspection of structure. Unable to find pipe on landward side. (O. Magana - DWR UCIP)  
FIELD\_STRUCT\_DESC: 24-inch corrugated metal gravity drainage pipe through the levee, 11.4 feet below the crown. Flap gate on the waterside (WS) end. Brass cap No. 50 bench mark (BM) on the headwall on the landside (LS). [Additional Reference(s): DWR Levee Log, 2002 (HLM 16.73), listed as a 24-inch corrugated metal pipe (CMP). USACE San Joaquin O&M Manual, Unit 601 Part 1 (SJR601.1), 1967, Revised 25 May 2011, (HLM 16.72), listed as a 24-inch CMP].

View of levee crown at crossing.

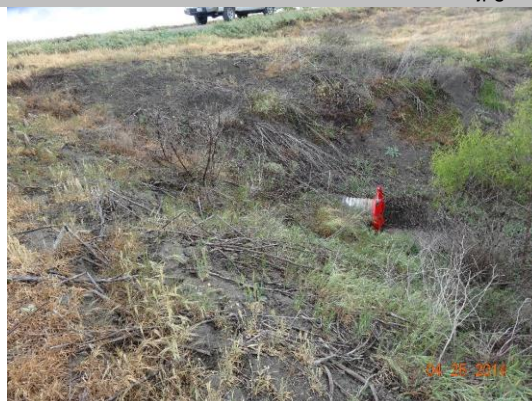
Photo 3 of 3 : UCIP\_SP\_2021\_62677\_66287.jpg

View of flap gate visible on waterward side.

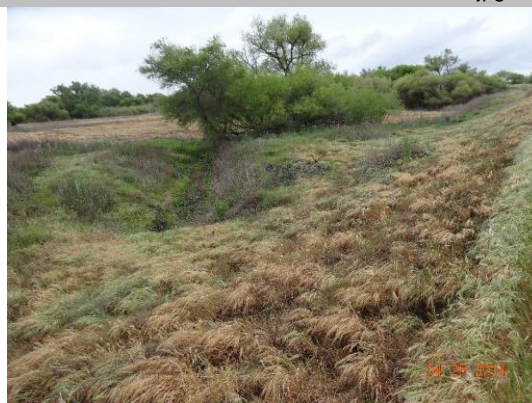
Photo 1 of 3 : UCIP\_SP\_2021\_62678\_65518.jpg

View of waterward side.

Comment Code					
Inspector Comment					
FS_ID:62678 DS_ID:19577 EP_NO: N/A Repair Type: Non-Urgent Crossing Status: Found UCIP Comments: 11/16/2020 Pipe status is still Non-Urgent. No permit was found authorizing this encroachment. CVFPB will need to review crossing to determine owner. DWR DMP has not found internal issues, LOF between 1 and 2. Recommend inspection in 5 years. (B. Singh - GEI, O. Magana - DWR UCIP)04/25/2014 Dense vegetation limits the inspector's visibility to identify signs of pipe failure (leaks) along the waterward and landward slopes. Concrete headwall is buried by dense vegetation. Recommend removing vegetation along pipe alignment to conduct proper inspection of structure. (O. Magana - DWR UCIP) FIELD_STRUCT_DESC: 24-inch corrugated metal gravity drainage pipe through the levee, 11.5 feet below the crown. Flap gate on the waterside (WS) end. Brass cap No. 50 bench mark (BM) on the headwall on the landside (LS). [Additional Reference(s): DWR Levee Log, 2002 (HLM 17.01), listed as a 24-inch corrugated metal pipe (CMP). USACE San Joaquin O&M Manual, Unit 601 Part 1 (SJR601.1), 1967, Revised 25 May 2011, (HLM 17.01), listed as a 24-inch CMP]. FS Date: 11/16/2020

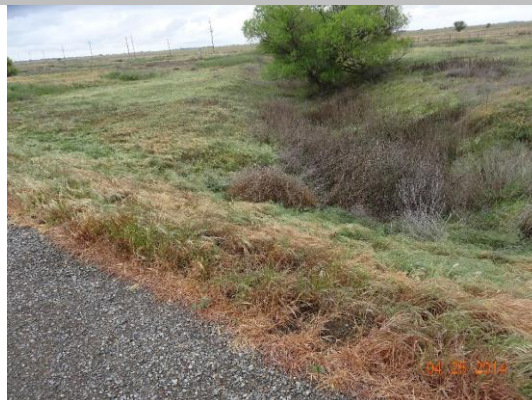
Photo 3 of 3 : UCIP\_SP\_2021\_62678\_65517.jpg

View of landward side.

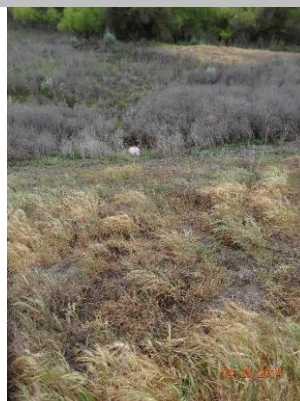
Photo 1 of 3 : UCIP\_SP\_2021\_62681\_65525.jpg

Comment Code						
Inspector Comment						
FS_ID:62681 DS_ID:19578 EP_NO: N/A Repair Type: Non-Urgent Crossing Status: Found UCIP Comments: 11/16/2020 Pipe status is still Non-Urgent. No permit was found authorizing this encroachment. CVFPB will need to review crossing to determine owner. DWR DMP has not found internal issues, LOF between 1 and 2. Recommend inspection in 5 years. (B. Singh - GEI, O. Magana - DWR UCIP)04/25/2014 Dense vegetation limits the inspector's visibility to identify signs of pipe failure (leaks) along the waterward and landward slopes. Recommend removing vegetation along pipe alignment to conduct proper inspection of structure. Sediment buildup inside pipe visible from landward side. Recommend clearing pipe. (O. Magana - DWR UCIP) FIELD_STRUCT_DESC: 24-inch corrugated metal gravity drainage pipe through the levee, 11.5 feet below the crown. Flap gate on the waterside (WS) end. Brass cap No. 50 bench mark (BM) on the headwall on the landside (LS). [Additional Reference(s): DWR Levee Log, 2002 (HLM 17.20), listed as a 24-inch corrugated metal pipe (CMP). USACE San Joaquin O&M Manual, Unit 601 Part 1 (SJR601.1), 1967, Revised 25 May 2011, (HLM 17.19), listed as a 24-inch CMP]. FS Date: 11/16/2020

View of waterward side.

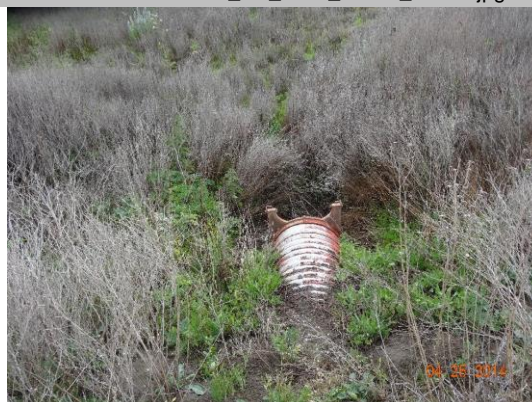
Photo 2 of 3 : UCIP\_SP\_2021\_62681\_65521.jpg

Pipe visible on waterward side.

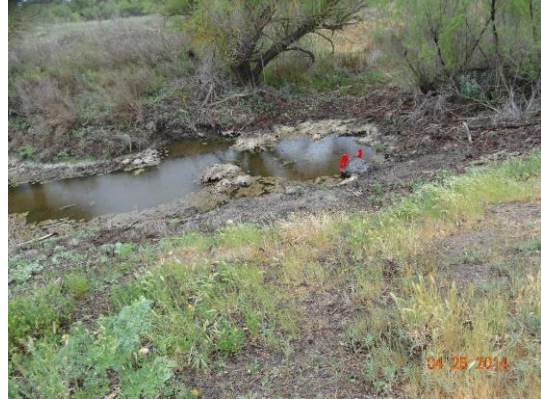
Photo 2 of 3 : UCIP\_SP\_2021\_62680\_65552.jpg

Pipe visible on waterward side.

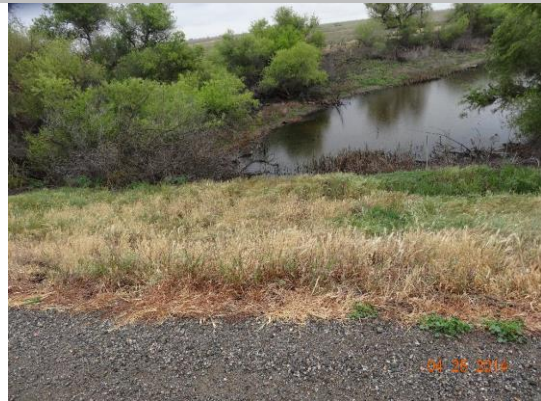
Photo 3 of 3 : UCIP\_SP\_2021\_62680\_65554.jpg

View of landward side.

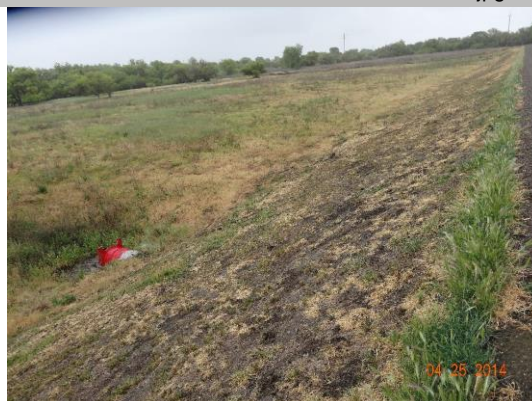
Photo 1 of 3 : UCIP\_SP\_2021\_62682\_65547.jpg

Comment Code						
Inspector Comment						
FS_ID:62682 DS_ID:19580 EP_NO: N/A Repair Type: Urgent Crossing Status: Found UCIP Comments: 11/16/2020 Pipe status is Urgent. Pipe collapse visible at LS toe through LS pipe riser, and in sinkhole 1 foot up-slope of the riser. No permit was found authorizing this encroachment. CVFPB will need to review crossing to determine owner. DWR DMP has not completed an internal inspection of the pipe but is scheduled for 2021. (B. Singh - GEI, O. Magana - DWR UCIP)04/25/2014 Dense vegetation limits the inspector's visibility to identify signs of pipe failure (leaks) along the landward slope. Recommend removing vegetation along pipe alignment to conduct proper inspection of structure. (O. Magana - DWR UCIP) FIELD_STRUCT_DESC: 24-inch corrugated metal gravity drainage pipe through the levee, 9.5 feet below the crown. Flap gate on the waterside (WS) end. Brass cap No. 50 bench mark (BM) on the headwall on the landside (LS). [Additional Reference(s): DWR Levee Log, 2002 (HLM 17.53), listed as a 24-inch corrugated metal pipe (CMP). USACE San Joaquin O&M Manual, Unit 601 Part 1 (SJR601.1), 1967, Revised 25 May 2011, (HLM 17.53), listed as a 24-inch CMP]. FS Date: 11/16/2020

View of waterward side.

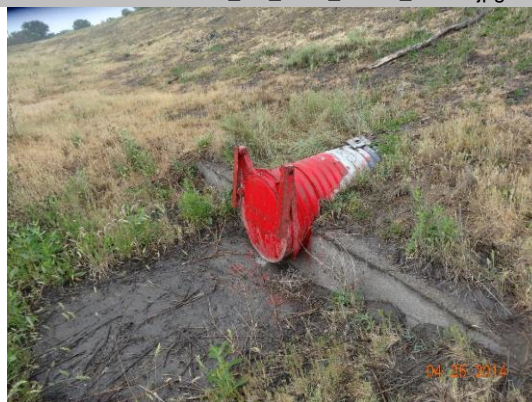
Photo 2 of 3 : UCIP\_SP\_2021\_62682\_65546.jpg

Flap gate visible on waterward side.

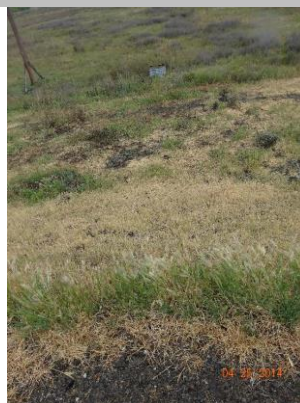
Photo 3 of 3 : UCIP\_SP\_2021\_62682\_65545.jpg

View of landward side--riser at levee toe.

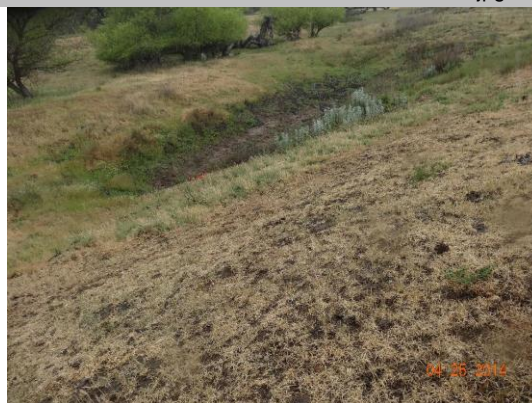
Photo 1 of 3 : UCIP\_SP\_2021\_62683\_65557.jpg

FS\_ID:62683  
DS\_ID:19581  
EP\_NO: N/A  
Repair Type: Urgent  
Crossing Status: Found  
UCIP Comments: 11/16/2020 Pipe status is Urgent. Considerable damage to pipe interior observed from LS toe. DWR DMP has found integrity issues, LOF between 5 and 6. Crossing will be monitored until funding becomes available for removal. No permit was found authorizing this encroachment. CVFPB will need to review crossing to determine owner. (B. Singh - GEI, O. Magana - DWR UCIP)04/25/2014 Need to contact owner. Recommend investigating integrity of pipe wall through levee heavy corrosion visible from landward side. (O. Magana - DWR UCIP)  
FIELD\_STRUCT\_DESC: 24-inch corrugated metal gravity drainage pipe through the levee, 11.5 feet below the crown. Flap gate on the waterside (WS) end. Brass cap No. 50 bench mark (BM) on the headwall on the landside (LS). [Additional Reference(s): DWR Levee Log, 2002 (HLM 18.21), listed as a 24-inch corrugated metal pipe (CMP). USACE San Joaquin O&M Manual, Unit 601 Part 1 (SJR601.1), 1967, Revised 25 May 2011, (HLM 18.19), listed as a 24-inch CMP].

View of waterward side.

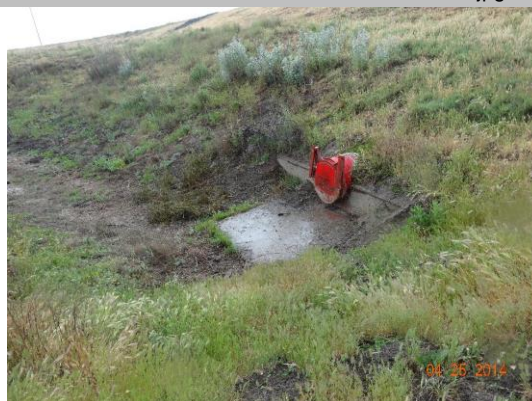
Photo 2 of 3 : UCIP\_SP\_2021\_62683\_65556.jpg

Flap gate visible on waterward side.

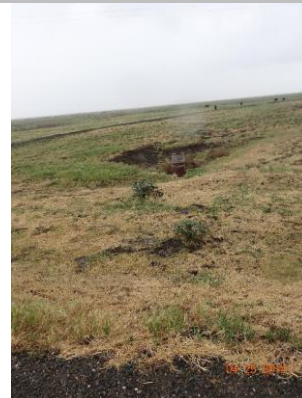
Photo 3 of 3 : UCIP\_SP\_2021\_62683\_65555.jpg

View of landward side.

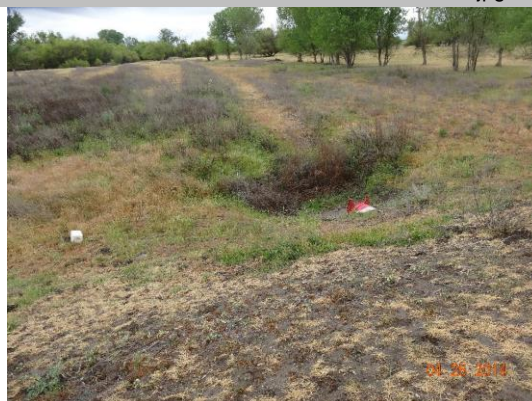
Photo 1 of 3 : UCIP\_SP\_2021\_62684\_65563.jpg

Comment Code						
Inspector Comment						
FS_ID:62684 DS_ID:19582 EP_NO: N/A Repair Type: Urgent Crossing Status: Found UCIP Comments: 11/16/2020 Pipe status is still Urgent. DWR DMP has found integrity issues, LOF between 5 and 6. Damage not observed in field inspection. Crossing will be monitored until funding becomes available for removal. No permit was found authorizing this encroachment. CVFPB will need to review crossing to determine owner. (B. Singh - GEI, O. Magana - DWR UCIP) FIELD_STRUCT_DESC: 24-inch corrugated metal gravity drainage pipe through the levee, 9.4 feet below the crown. Flap gate on the waterside (WS) end. Brass cap No. 50 bench mark (BM) on the headwall on the landside (LS). [Additional Reference(s): DWR Levee Log, 2002 (HLM 18.47), listed as a 24-inch corrugated metal pipe (CMP). USACE San Joaquin O&M Manual, Unit 601 Part 1 (SJR601.1), 1967, Revised 25 May 2011, (HLM 18.45), listed as a 24-inch CMP]. FS Date: 11/16/2020

View of waterward side.

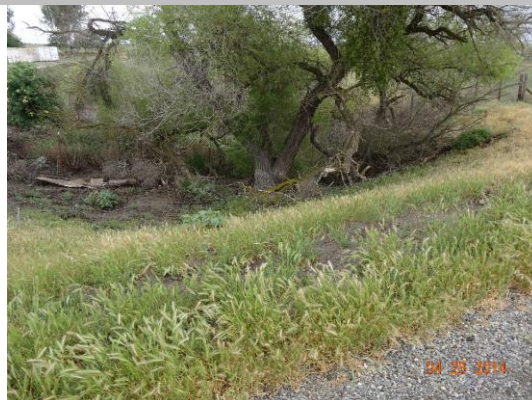
Photo 3 of 3 : UCIP\_SP\_2021\_62749\_65626.jpg

Overview of landward side.

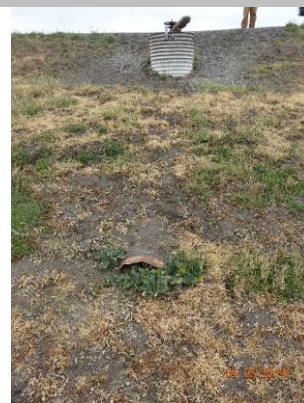
Photo 1 of 3 : UCIP\_SP\_2021\_62685\_65631.jpg

Comment Code						
Inspector Comment						
FS_ID:62685 DS_ID:19594 EP_NO: N/A Repair Type: Non-Urgent Crossing Status: Found UCIP Comments: 11/16/2020 Pipe status is still Non-Urgent. Sediment build-up observed at LS inlet; recommend sediment removal. No permit was found authorizing this encroachment. CVFPB will need to review crossing to determine owner. DWR DMP has not completed an internal inspection of the pipe but is scheduled for 2021. (B. Singh - GEI, O. Magana - DWR UCIP)04/25/2014 Non-functional crossing--pipe is buried on waterward side. Sediment buildup in pipe visible from landward side. Need to coordinate with owner to determine status. If crossing is no longer in use, owner will need to coordinate with DWR Inspector and CVFPB to properly abandon. (O. Magana - DWR UCIP) FIELD_STRUCT_DESC: 24-inch corrugated metal gravity drainage pipe through the levee, 13 feet below the crown. Flap gate on the waterside (WS) end. Brass cap No. 40 bench mark (BM) on the headwall on the landside (LS). [Additional Reference(s): DWR Levee Log, 2002 (HLM 19.18), listed as a 24-inch corrugated metal pipe (CMP). USACE San Joaquin O&M Manual, Unit 601 Part 1 (SJR601.1), 1967, Revised 25 May 2011, (HLM 19.17), listed as a 24-inch CMP]. FS Date: 11/16/2020

View of waterward slope. CMP riser and pipe visible.

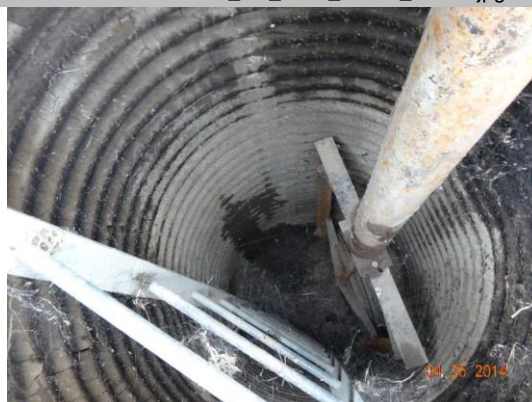
Photo 2 of 3 : UCIP\_SP\_2021\_62685\_65632.jpg

Inside view of CMP riser.

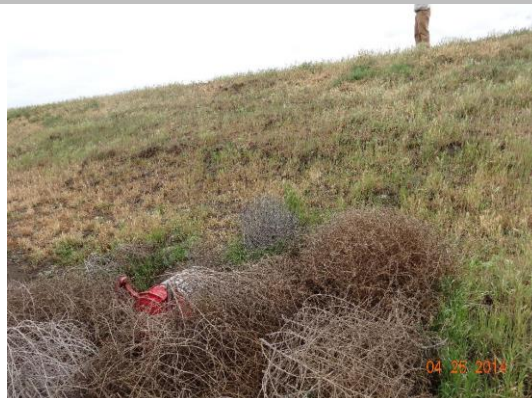
Photo 2 of 3 : UCIP\_SP\_2021\_62691\_65640.jpg

Flap gate visible on waterward side--potential erosion present on slope.

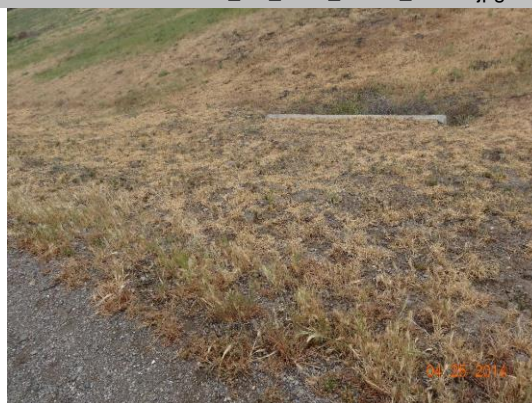
Photo 3 of 3 : UCIP\_SP\_2021\_62691\_65639.jpg

View of landward slope.

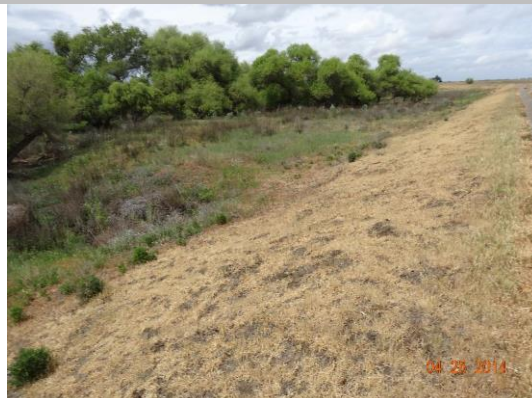
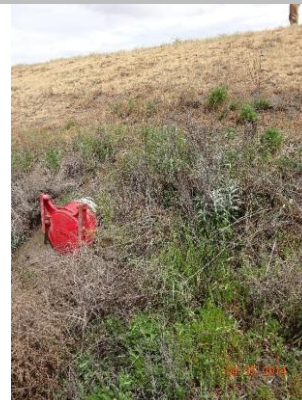
LM Start	<b>20.18</b>	Rating **	M	Issue No.	<b>91 (cont)</b>
LM End	<b>20.18</b>	Issue Type +	Ma	Location *

FS\_ID:62693  
DS\_ID:19598  
EP\_NO: N/A  
Repair Type: Non-Urgent  
Crossing Status: Found  
UCIP Comments: 11/16/2020 Pipe status is still Non-Urgent. Limited access due to steep slopes. No permit was found authorizing this encroachment. CVFPB will need to review crossing to determine owner. DWR DMP has not completed an internal inspection of the pipe but is scheduled for 2021. (B. Singh - GEI, O. Magana - DWR UCIP)04/25/2014 Recommend removing vegetation and sediment buildup from both waterward and landward concrete headwalls. (O. Magana - DWR UCIP)  
FIELD\_STRUCT\_DESC: 24-inch corrugated metal gravity drainage pipe through the levee, 8.5 feet below the crown. Flap gate on the waterside (WS) end. Brass cap No. 40 bench mark (BM) on the headwall on the landside (LS). [Additional Reference(s): DWR Levee Log, 2002 (HLM 20.19), listed as a 24-inch corrugated metal pipe (CMP). USACE San Joaquin O&M Manual, Unit 601 Part 1 (SJR601.1), 1967, Revised 25 May 2011, (HLM 20.18), listed as a 24-inch CMP].

Flap gate visible on WS toe.

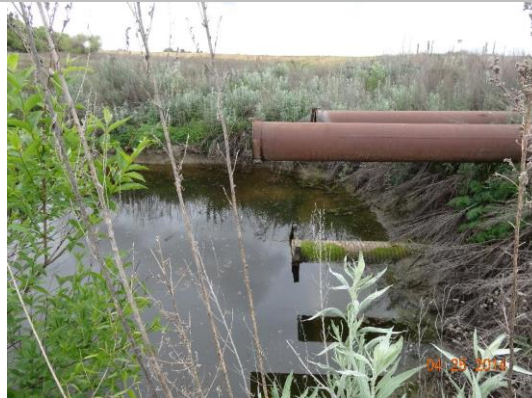
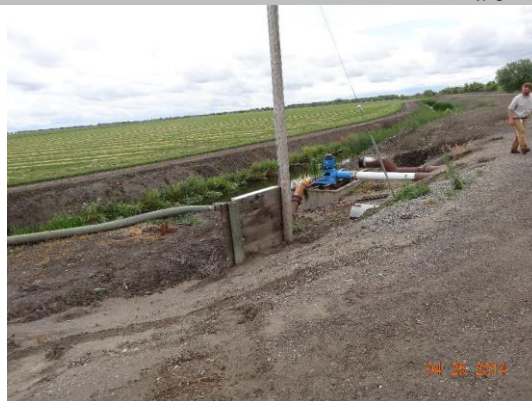
LM Start	20.27	Rating **	M	Issue No.	123 (cont)
LM End	20.27	Issue Type +	Ma	Location *	
Category	Supplemental			GPS Latitude/Longitude	
				Start	End
Item	DWR UCIP LMA Responsibility			37.193542 °	37.193542 °
				-120.760300 °	-120.760300 °
DWR ID	19600

Multiple crossings visible on waterward side--36 inch CMP is submersed in water.

View of landward side.

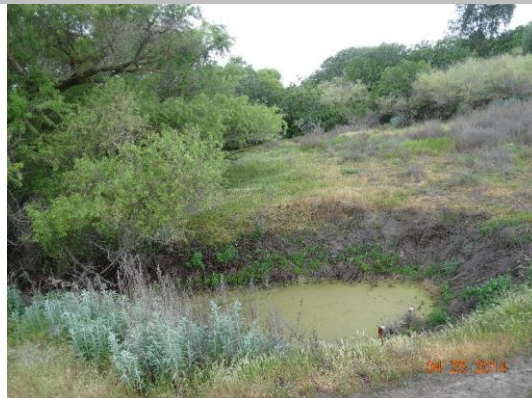
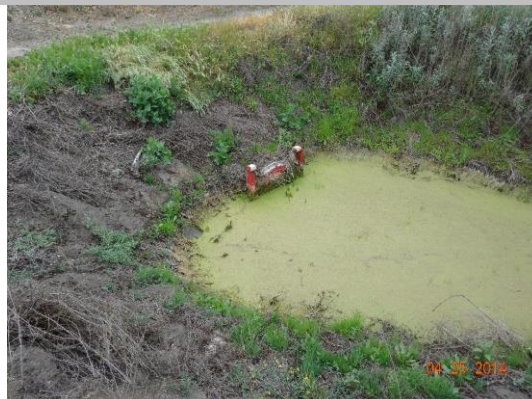
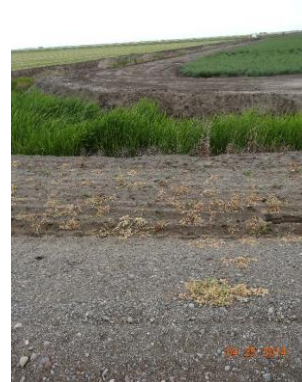
LM Start	<b>21.40</b>	Rating **	M	Issue No.	<b>125 (cont)</b>
LM End	<b>21.40</b>	Issue Type +	Ma	Location *

FS\_ID:61910  
DS\_ID:19603  
EP\_NO: N/A  
Repair Type: Non-Urgent  
Crossing Status: Found  
UCIP Comments: 04/25/2014 Crossing is non-functional--crossing buried on landward side. Need to contact owner to determine status of crossing. If crossing is no longer used need to coordinate with CVFPB for proper abandonment. (O. Magana - DWR UCIP)  
FIELD\_STRUCT\_DESC: 36-inch corrugated metal gravity drainage pipe through the levee, 11.5 feet below the crown. Flap gate on the waterside (WS) end. Brass cap No. 40 bench mark (BM) on the headwall on the landside (LS). [Additional Reference(s): DWR Levee Log, 2002 (HLM 21.41), listed as a 36-inch corrugated metal pipe (CMP). USACE San Joaquin O&M Manual, Unit 601 Part 1 (SJR601.1), 1967, Revised 25 May 2011, (HLM 21.40), listed as a 36-inch CMP].  
FS Date: 4/25/2014

View of waterward side.

Flap gate half way submersed located on waterward side.

View of landward side.

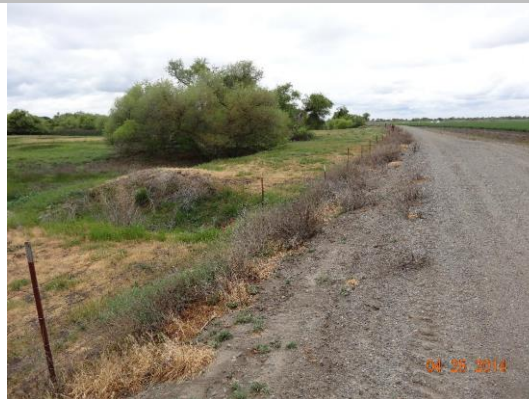
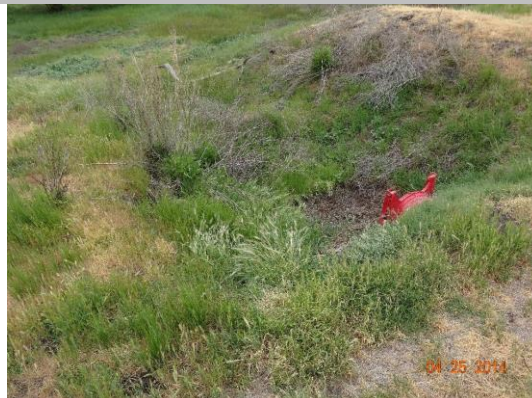
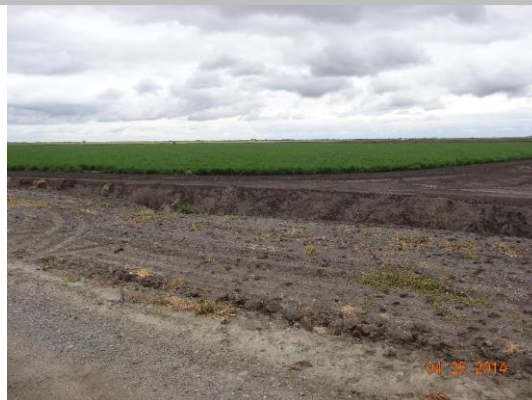
LM Start	<b>21.75</b>	Rating **	M	Issue No.	<b>126</b>
LM End	<b>21.75</b>	Issue Type +	Ma	Location *	
Category	Supplemental		GPS Latitude/Longitude		
			Start	End	
Item	DWR UCIP LMA Responsibility		37.176106 °	37.176106 °	
			-120.756768 °	-120.756768 °	
DWR ID	19604

FS\_ID:61911  
DS\_ID:19604  
EP\_NO: N/A  
Repair Type: Non-Urgent  
Crossing Status: Found  
UCIP Comments: 04/25/2014 Non-functional crossing-landward side is buried. Need to contact owner to determine status of crossing. If crossing is no longer used need to coordinate with CVFPB for proper abandonment. (O. Magana - DWR UCIP)  
FIELD\_STRUCT\_DESC: 24-inch corrugated metal gravity drainage pipe through the levee, 9 feet below the crown. Flap gate on the waterside (WS) end. Brass cap No. 40 bench mark (BM) on the headwall on the landside (LS). [Additional Reference(s): DWR Levee Log, 2002 (HLM 21.78), listed as a 24-inch corrugated metal pipe (CMP). USACE San Joaquin O&M Manual, Unit 601 Part 1 (SJR601.1), 1967, Revised 25 May 2011, (HLM 21.76), listed as a 24-inch CMP].  
FS Date: 4/25/2014

View of waterward side.

Flap gate visible on waterward side.

View of landward side.

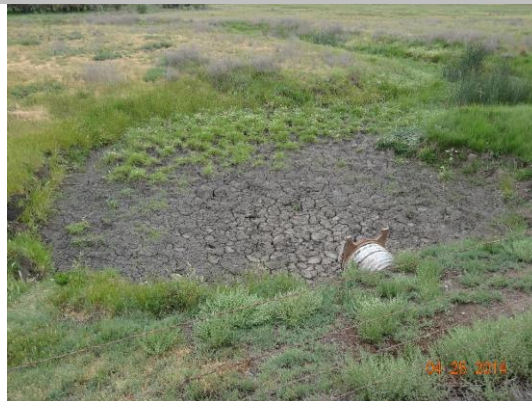
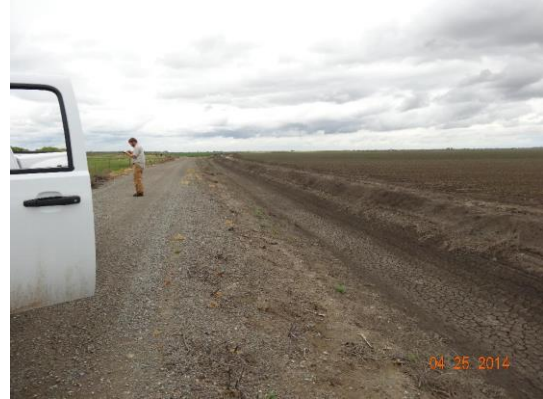
LM Start	<b>22.12</b>	Rating **	M	Issue No.	<b>127 (cont)</b>
LM End	<b>22.12</b>	Issue Type +	Ma	Location *

Comment Code					
Inspector Comment					
FS_ID:61912 DS_ID:19605 EP_NO: N/A Repair Type: Non-Urgent Crossing Status: Found UCIP Comments: 04/25/2014 Non-functional crossing--landward side is buried. Need to contact owner to determine status. If crossing is no longer used need to coordinate with CVFPB for proper abandonment. (O. Magana - DWR UCIP) FIELD_STRUCT_DESC: 24-inch corrugated metal gravity drainage pipe through the levee, 9 feet below the crown. Flap gate on the waterside (WS) end. Wooden headboards on the landside (LS) end. Brass cap No. 31 bench mark (BM) on the headwall on the LS. [Additional Reference(s): DWR Levee Log, 2002 (HLM 22.13), listed as a 24-inch corrugated metal pipe (CMP). USACE San Joaquin O&M Manual, Unit 601 Part 1 (SJR601.1), 1967, Revised 25 May 2011, (HLM 22.13), listed as a 24-inch CMP]. FS Date: 4/25/2014

View of waterward side.

Flap gate visible on waterward side.

View of landward side.

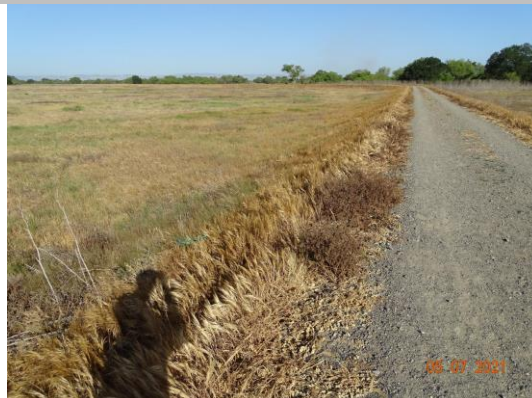
Photo 1 of 1 : SP\_2021\_NA0010\_119\_24\_20210517\_00065.jpg

LM Start	0.01	Rating **	M	Issue No.	24
LM End	3.57	Issue Type +	Ma	Location *	LS
Category	Earthen Levee			GPS Latitude/Longitude	
				Start	End
Item	Vegetation			37.296263 °	37.278144 °
				-120.880413 °	-120.840598 °
DWR ID	DWR_NA0010_02A_s _ 2021_24				
Comment Code					
V1 : Control annual grass and weeds on the levee slopes and easements.					
Inspector Comment

View of the landside slope looking downstream. (Spring 2021)

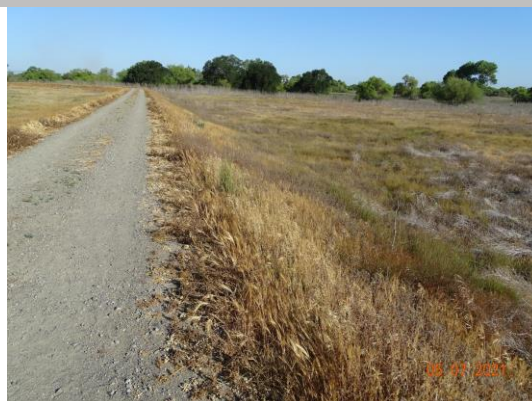
Photo 1 of 1 : SP\_2021\_NA0010\_119\_25\_20210517\_00066.jpg

LM Start	0.01	Rating **	M	Issue No.	25
LM End	3.66	Issue Type +	Ma	Location *	WS
Category	Earthen Levee			GPS Latitude/Longitude	
				Start	End
Item	Vegetation			37.296263 °	37.278699 °
				-120.880413 °	-120.839126 °
DWR ID	DWR_NA0010_02A_s _ 2021_25				
Comment Code					
V1 : Control annual grass and weeds on the levee slopes and easements.					
Inspector Comment

View of the waterside slope looking downstream. (Spring 2021)

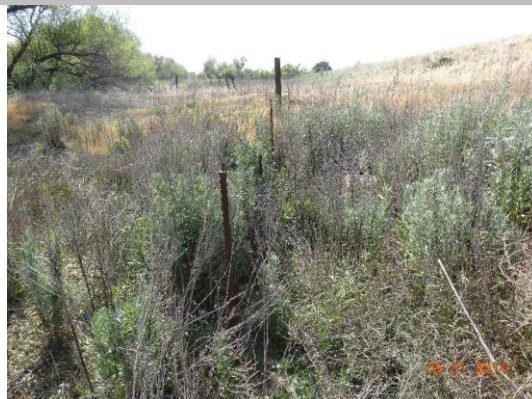
LM Start	<b>0.23</b>	Rating **	M	Issue No.	<b>3 (cont)</b>
LM End	<b>0.23</b>	Issue Type +	Ma	Location *

FS\_ID:61974  
DS\_ID:19652  
EP\_NO: N/A  
Repair Type: Non-Urgent  
Crossing Status: Found  
UCIP Comments: 05/01/2014 Dense vegetation limits the inspector's visibility to identify signs of pipe failure (leaks) along the slope. Recommend removing vegetation along pipe alignment to conduct proper inspection of structure. (O. Magana - DWR UCIP)  
FIELD\_STRUCT\_DESC: 24-inch corrugated metal gravity drainage pipe through the levee, 11 feet below the crown. Flap gate on the waterside (WS) end. Brass cap No. 139 bench mark (BM) on the headwall on the landside (LS). [Additional Reference(s): DWR Levee Log, 2002 (HLM 0.24), listed as a 24-inch corrugated metal pipe (CMP). USACE San Joaquin O&M Manual, Unit 601 Part 1 (SJR 601.1), 1967, Revised 25 May 2011, (HLM 0.24), listed as a 24-inch CMP].  
FS Date: 5/1/2014

View of waterward side.

Fence along waterward side. No headwall was found on waterward side.

View of landward side.

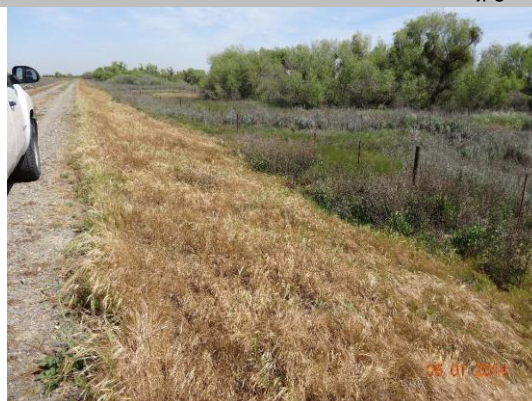
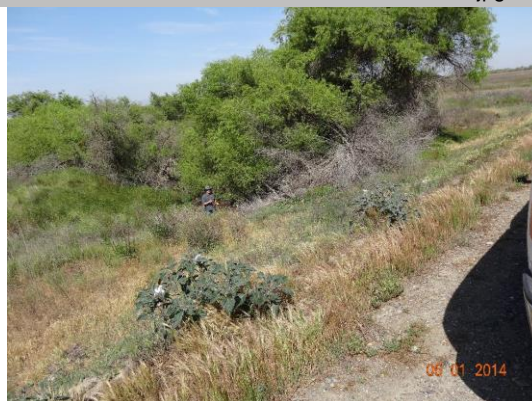
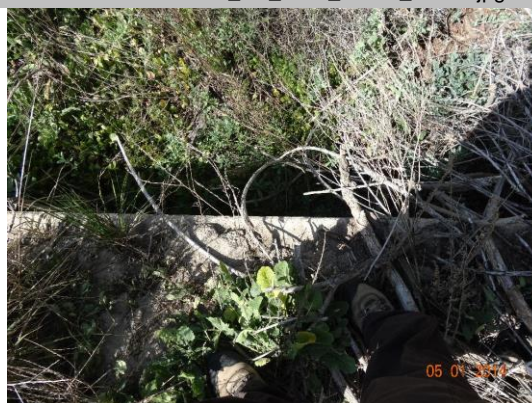
LM Start	0.66	Rating **	M	Issue No.	4
LM End	0.66	Issue Type +	Ma	Location *	
Category	Supplemental			GPS Latitude/Longitude	
				Start	End
Item	DWR UCIP LMA Responsibility			37.288087 °	37.288087 °
				-120.874919 °	-120.874919 °
DWR ID	19653

FS\_ID:61976  
DS\_ID:19653  
EP\_NO: N/A  
Repair Type: Non-Urgent  
Crossing Status: Found  
UCIP Comments: 05/01/2014 Dense vegetation limits the inspector's visibility to identify signs of pipe failure (leaks) along the slope. Recommend removing vegetation along pipe alignment to conduct proper inspection of structure. (O. Magana - DWR UCIP)  
FIELD\_STRUCT\_DESC: 24-inch corrugated metal gravity drainage pipe through the levee, 14.8 feet below the crown. Flap gate on the waterside (WS) end. Brass cap No. 138 bench mark (BM) on the headwall on the landside (LS). [Additional Reference(s): DWR Levee Log, 2002 (HLM 0.69), listed as a 24-inch corrugated metal pipe (CMP). USACE San Joaquin O&M Manual, Unit 601 Part 1 (SJR 601.1), 1967, Revised 25 May 2011, (HLM 0.67), listed as a 24-inch CMP].  
FS Date: 5/1/2014

View of waterward side.

View of landward side.

Concrete headwall found on landward side.

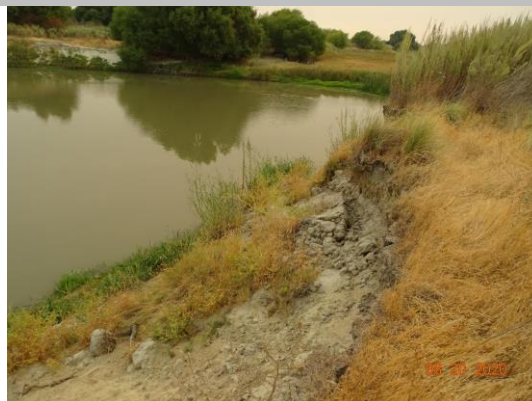
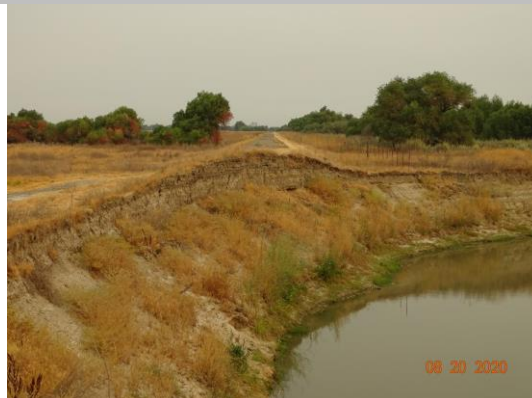
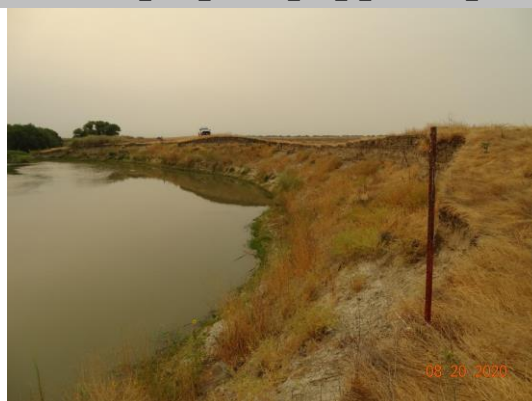
LM Start	<b>0.68</b>	Rating **	U	Issue No.	<b>1</b>
LM End	<b>0.75</b>	Issue Type +	Ma	Location *	WS
Category	Supplemental		GPS Latitude/Longitude		
			Start	End	
Item	DWR Erosion Survey		37.287517 °	37.287517 °	
			-120.874583 °	-120.874583 °	
DWR ID	NA0010U02ARM129.22

08/20/2020: This site was discovered during the DWR Spring 2012 Levee Inspections. A 250-ft long levee section has completely eroded away and no longer provides adequate flood protection. Note: Unit 2A is in the process of being turned over to State Parks.

8/20/2020: View of the upstream end of the erosion looking upstream.

8/20/2020: View of the eroded levee section looking downstream.

8/20/2020: View of the eroded levee section looking upstream.

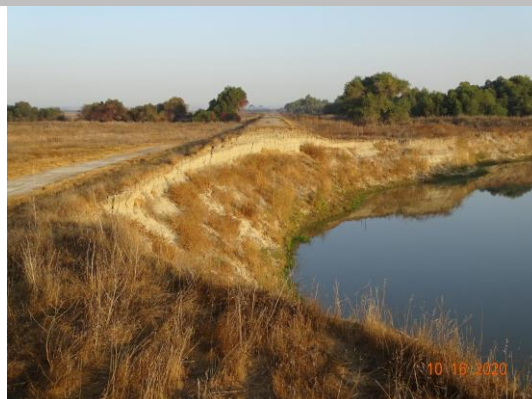
Photo 1 of 1 : SP\_2021\_NA0010\_119\_5\_20210308\_00005.jpg

LM Start	0.75	Rating **	U	Issue No.	5
LM End	0.78	Issue Type +	Ma	Location *	WS
Category	Earthen Levee			GPS Latitude/Longitude	
				Start	End
Item	Erosion / Bank Caving			37.287517 °	37.286543 °
				-120.874583 °	-120.873935 °
DWR ID	DWR_NA0010_02A_s_2012_5				
Comment Code					
E2 : Schedule repair of erosion site prior to the next inspection.					
Inspector Comment					
This section of the levee unit is in the process of being turned over to State Parks.

Looking downstream at erosion through the waterside slope and crown.  
(Fall 2020)

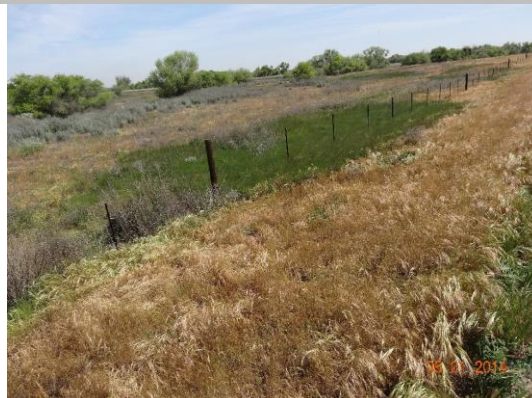
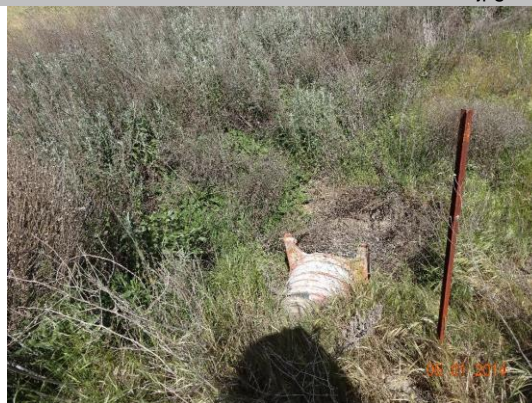
LM Start	<b>1.01</b>	Rating **	M	Issue No.	<b>6 (cont)</b>
LM End	<b>1.01</b>	Issue Type +	Ma	Location *

Comment Code						
Inspector Comment						
FS_ID:61977 DS_ID:19654 EP_NO: N/A Repair Type: Non-Urgent Crossing Status: Found UCIP Comments: 05/01/2014 Dense vegetation limits the inspector's visibility to identify signs of pipe failure (leaks) along the slope. Recommend removing vegetation along pipe alignment to conduct proper inspection of structure. Sediment buildup in pipe recommend clearing. (O. Magana - DWR UCIP) FIELD_STRUCT_DESC: 24-inch corrugated metal gravity drainage pipe through the levee, 8.6 feet below the crown. Flap gate on the waterside (WS) end. Brass cap No. 137 bench mark (BM) on the headwall on the landside (LS). [Additional Reference(s): DWR Levee Log, 2002 (HLM 1.03), listed as a 24-inch corrugated metal pipe (CMP). USACE San Joaquin O&M Manual, Unit 601 Part 1 (SJR 601.1), 1967, Revised 25 May 2011, (HLM 1.02), listed as a 24-inch CMP]. FS Date: 5/1/2014

View of waterward side.

Pipe visible on waterward side.

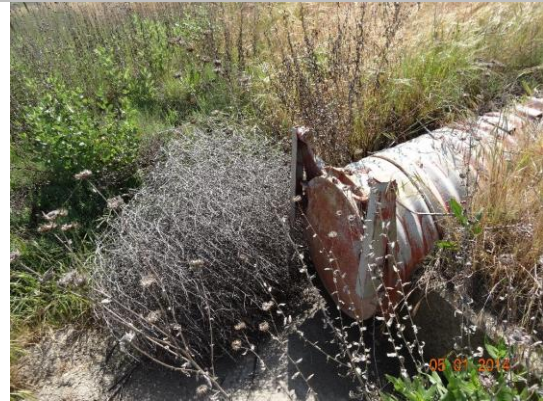
Photo 2 of 3 : UCIP\_SP\_2021\_61979\_66117.jpg

Flap gate visible on waterward side.

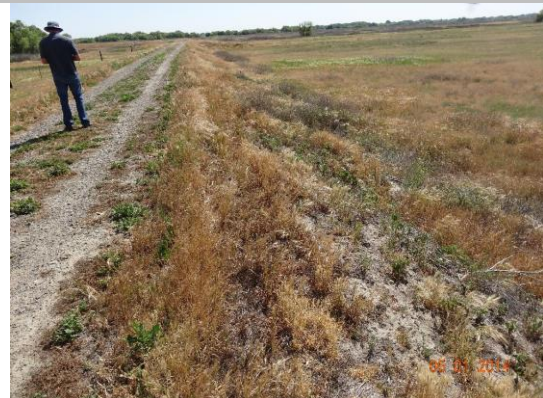
Photo 3 of 3 : UCIP\_SP\_2021\_61979\_66116.jpg

View of landward side.

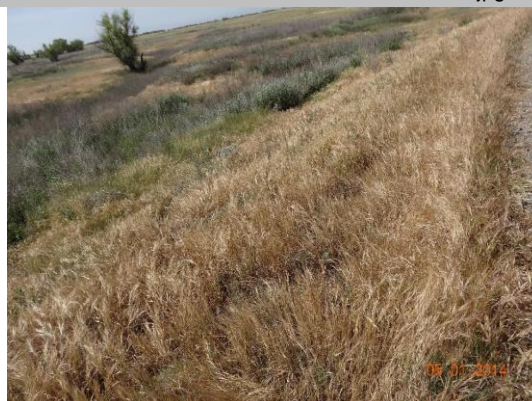
Photo 1 of 3 : UCIP\_SP\_2021\_62000\_66120.jpg

FS\_ID:62000  
DS\_ID:19656  
EP\_NO: N/A  
Repair Type: Non-Urgent  
Crossing Status: Found  
UCIP Comments: 05/01/2014 Dense vegetation limits the inspector's visibility to identify signs of pipe failure (leaks) along the slope. Recommend removing vegetation along pipe alignment to conduct proper inspection of structure. (O. Magana - DWR UCIP)  
FIELD\_STRUCT\_DESC: 36-inch corrugated metal gravity drainage pipe through the levee, 14.6 feet below the crown. Flap gate on the waterside (WS) end. Brass cap No. 135 bench mark (BM) on the headwall on the landside (LS). [Additional Reference(s): DWR Levee Log, 2002 (HLM 1.36), listed as a 36-inch corrugated metal pipe (CMP). USACE San Joaquin O&M Manual, Unit 601 Part 1 (SJR 601.1), 1967, Revised 25 May 2011, (HLM 1.34), listed as a 36-inch CMP].  
FS Date: 5/1/2014

View of landward side.

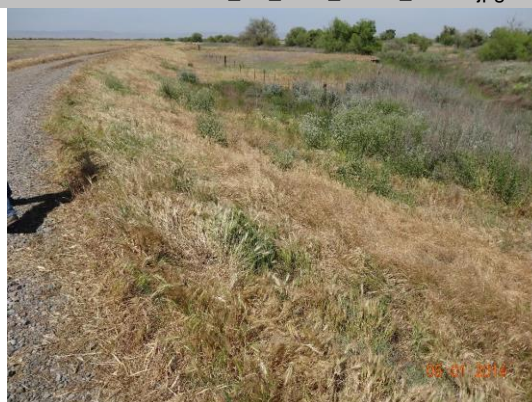
Photo 2 of 3 : UCIP\_SP\_2021\_62000\_66119.jpg

View of waterward side.

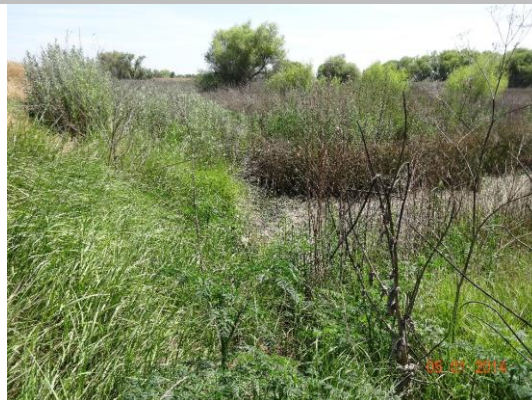
Photo 2 of 3 : UCIP\_SP\_2021\_61981\_66123.jpg

Dense vegetation along levee slope and toe.

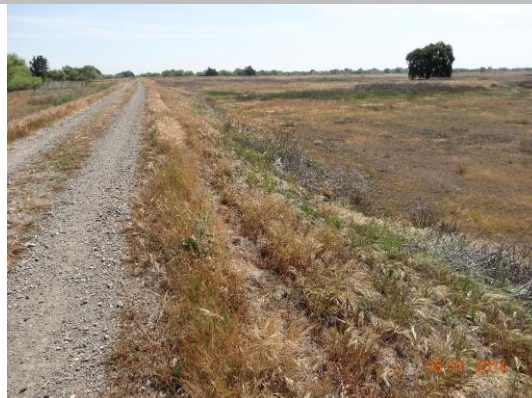
Photo 1 of 3 : UCIP\_SP\_2021\_61982\_66129.jpg

Comment Code						
Inspector Comment						
FS_ID:61982 DS_ID:19658 EP_NO: N/A Repair Type: Non-Urgent Crossing Status: Found UCIP Comments: 05/01/2014 Dense vegetation limits the inspector's visibility to identify signs of pipe failure (leaks) along the slope. Recommend removing vegetation along pipe alignment to conduct proper inspection of structure. (O. Magana - DWR UCIP) FIELD_STRUCT_DESC: 24-inch corrugated metal gravity drainage pipe through the levee, 10.7 feet below the crown. Flap gate on the waterside (WS) end. Brass cap No. 135 bench mark (BM) on the headwall on the landside (LS). [Additional Reference(s): DWR Levee Log, 2002 (HLM 1.88), listed as a 24-inch corrugated metal pipe (CMP). USACE San Joaquin O&M Manual, Unit 601 Part 1 (SJR 601.1), 1967, Revised 25 May 2011, (HLM 1.86), listed as a 24-inch CMP]. FS Date: 5/1/2014

View of landward side.

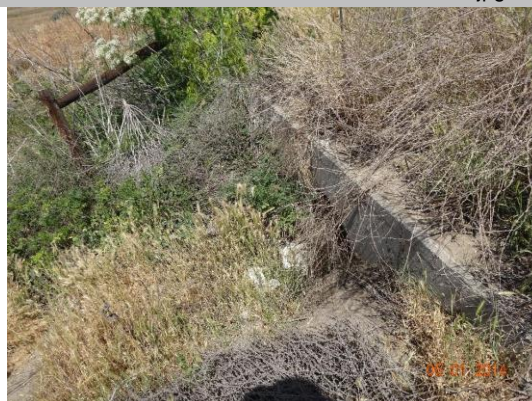
Photo 2 of 3 : UCIP\_SP\_2021\_61984\_66132.jpg

Concrete headwall visible on landward side.

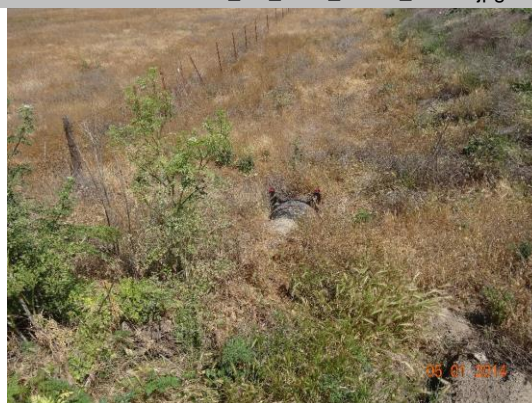
Photo 3 of 3 : UCIP\_SP\_2021\_61984\_66131.jpg

View of pipe through levee visible on waterward side.

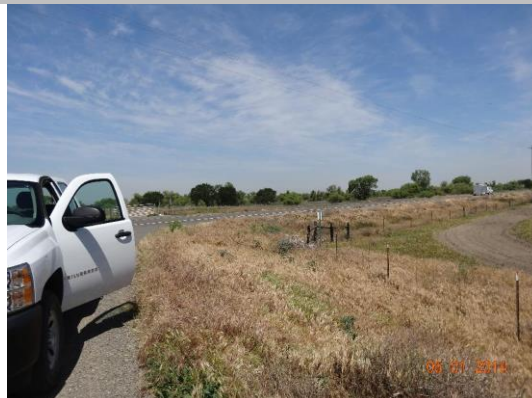
Photo 1 of 3 : UCIP\_SP\_2021\_61985\_66137.jpg

Comment Code						
Inspector Comment						
FS_ID:61985 DS_ID:19660 EP_NO: N/A Repair Type: Non-Urgent Crossing Status: Found UCIP Comments: 05/01/2014 Dense vegetation limits the inspector's visibility to identify signs of pipe failure (leaks) along the slope. Recommend removing vegetation along pipe alignment to conduct proper inspection of structure. (O. Magana - DWR UCIP) FIELD_STRUCT_DESC: 24-inch corrugated metal gravity drainage pipe through the levee, 7 feet below the crown. Flap gate on the waterside (WS) end. Brass cap No. 135 bench mark (BM) on the headwall on the landside (LS). [Additional Reference(s): DWR Levee Log, 2002 (HLM 2.34), listed as a 24-inch corrugated metal pipe (CMP). USACE San Joaquin O&M Manual, Unit 601 Part 1 (SJR 601.1), 1967, Revised 25 May 2011, (HLM 2.32), listed as a 24-inch CMP]. FS Date: 5/1/2014

View of waterward side.

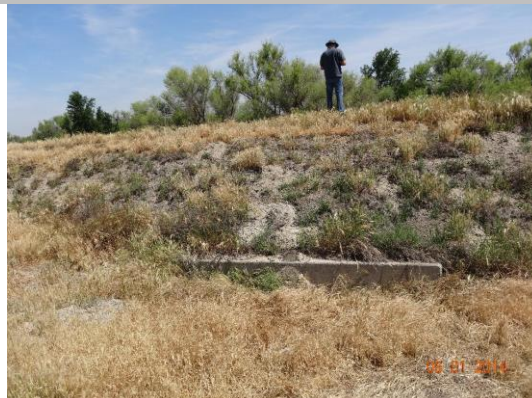
Photo 2 of 3 : UCIP\_SP\_2021\_61986\_66141.jpg

Concrete headwall visible on landward side.

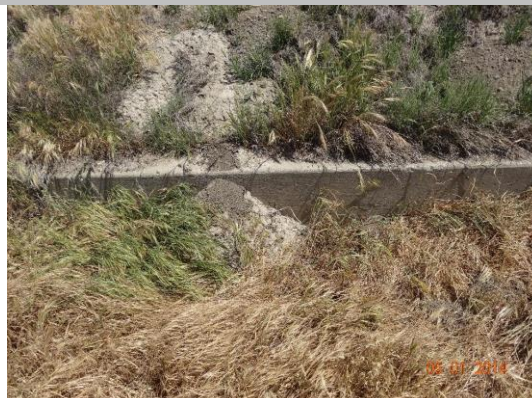
Photo 3 of 3 : UCIP\_SP\_2021\_61986\_66140.jpg

Non-functional crossing concrete headwall and inlet buried on landward side.

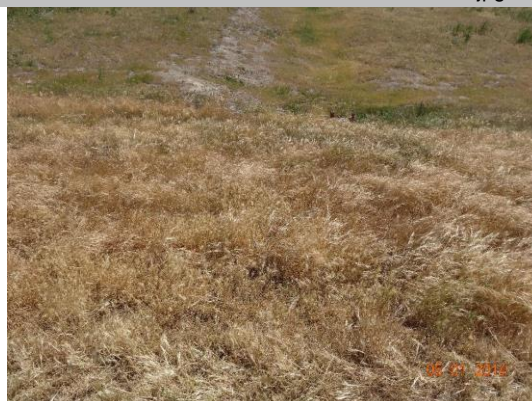
Photo 1 of 3 : UCIP\_SP\_2021\_61987\_66145.jpg

Comment Code					
Inspector Comment					
FS_ID:61987 DS_ID:19662 EP_NO: N/A Repair Type: Non-Urgent Crossing Status: Found UCIP Comments: 05/01/2014 Dense vegetation limits the inspector's visibility to identify signs of pipe failure (leaks) along the slope. Recommend removing vegetation along pipe alignment to conduct proper inspection of structure. (O. Magana - DWR UCIP) FIELD_STRUCT_DESC: 24-inch corrugated metal gravity drainage pipe through the levee, 10 feet below the crown. Flap gate on the waterside (WS) end. Brass cap No. 130 bench mark (BM) on the headwall on the landside (LS). [Additional Reference(s): DWR Levee Log, 2002 (HLM 2.97), listed as a 24-inch corrugated metal pipe (CMP). USACE San Joaquin O&M Manual, Unit 601 Part 1 (SJR 601.1), 1967, Revised 25 May 2011, (HLM 2.96), listed as a 24-inch CMP]. FS Date: 5/1/2014

View of waterward side.

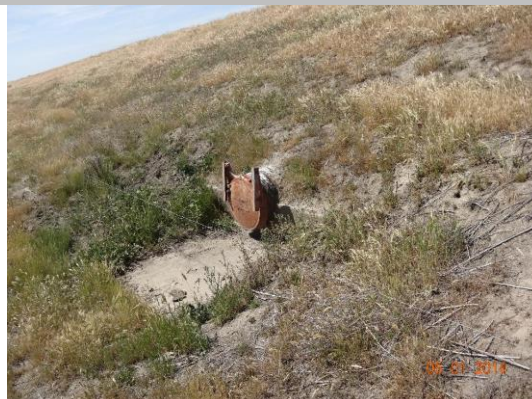
Photo 2 of 3 : UCIP\_SP\_2021\_61987\_66144.jpg

Flap gate visible on waterward side.

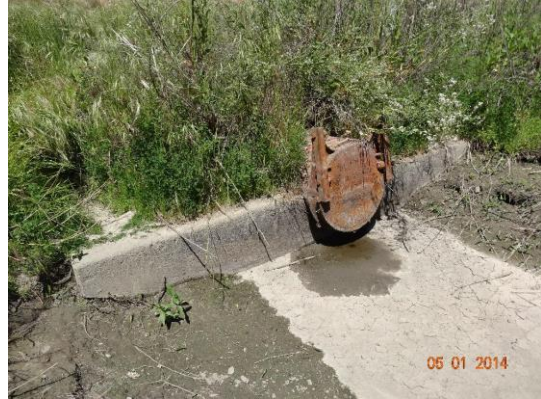
Photo 2 of 3 : UCIP\_SP\_2021\_61988\_66153.jpg

Flap gate visible on waterward side.
