**Flood Control Project Maintenance  
Levee Inspections**

## Maintenance Issue Types Only, Levee Inspection Report By Mile - Spring 2021

### Lower San Joaquin Levee District

Waterway	Bank	Unit Miles	Inspection Start/End	Inspector
Unit No. 01 San Joaquin River	Right	22.52	05/04/2021 05/04/2021	Corey Fujitani

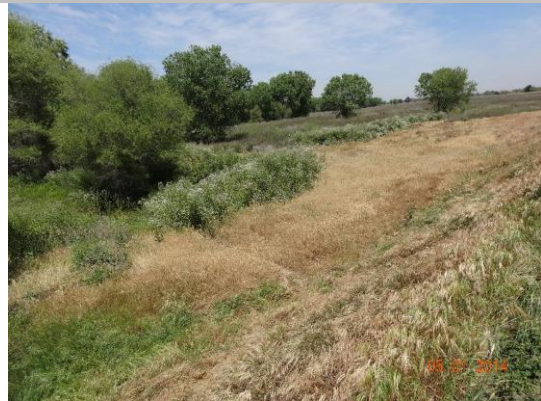
Photo 3 of 3 : UCIP\_SP\_2021\_61988\_66152.jpg

View of landward side.

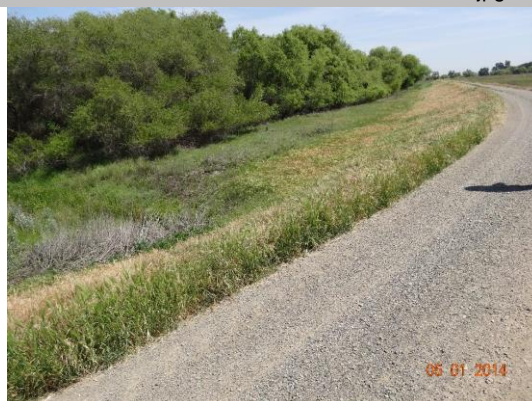
Photo 1 of 3 : UCIP\_SP\_2021\_61989\_66155.jpg

Comment Code						
Inspector Comment						
FS_ID:61989 DS_ID:19666 EP_NO: N/A Repair Type: Non-Urgent Crossing Status: Found UCIP Comments: 05/01/2014 Dense vegetation limits the inspector's visibility to identify signs of pipe failure (leaks) along the slope. Recommend removing vegetation along pipe alignment to conduct proper inspection of structure. (O. Magana - DWR UCIP) FIELD_STRUCT_DESC: 24-inch corrugated metal gravity drainage pipe through the levee, 10 feet below the crown. Flap gate on the waterside (WS) end. Brass cap No. 130 bench mark (BM) on the headwall on the landside (LS). [Additional Reference(s): DWR Levee Log, 2002 (HLM 3.63), listed as a 24-inch corrugated metal pipe (CMP). USACE San Joaquin O&M Manual, Unit 601 Part 1 (SJR 601.1), 1967, Revised 25 May 2011, (HLM 3.62), listed as a 24-inch CMP]. FS Date: 5/1/2014

View of waterward side.

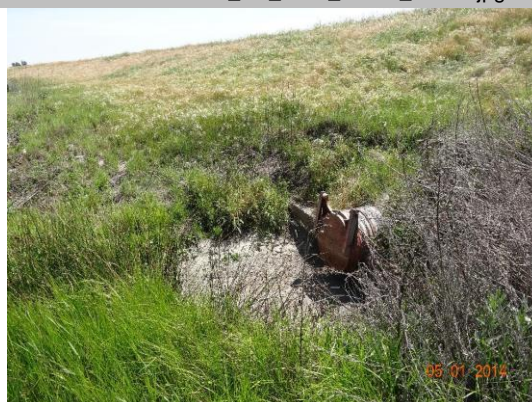
Photo 2 of 3 : UCIP\_SP\_2021\_61989\_66154.jpg

Flap gate visible on waterward side.

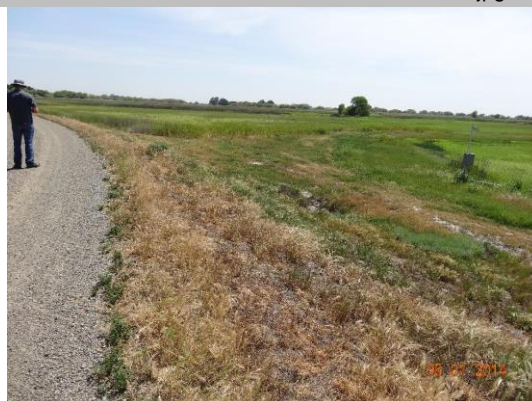
Photo 3 of 3 : UCIP\_SP\_2021\_61989\_66156.jpg

View of landward side.

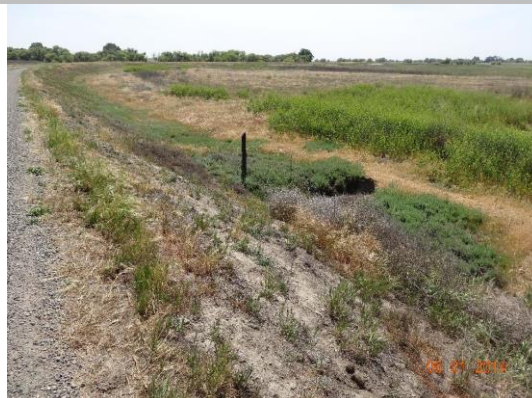
Photo 1 of 3 : UCIP\_SP\_2021\_61990\_66161.jpg

Comment Code						
Inspector Comment						
FS_ID:61990 DS_ID:19667 EP_NO: N/A Repair Type: Non-Urgent Crossing Status: Found UCIP Comments: 05/01/2014 Signs of erosion or sink hole present on landward toe--Need to contact owner. Dense vegetation limits the inspector's visibility to identify signs of pipe failure (leaks) along the slope. Recommend removing vegetation along pipe alignment to conduct proper inspection of structure. (O. Magana - DWR UCIP) FIELD_STRUCT_DESC: 24-inch corrugated metal gravity drainage pipe through the levee, 8.6 feet below the crown. Flap gate on the waterside (WS) end. Brass cap No. 130 bench mark (BM) on the headwall on the landside (LS). [Additional Reference(s): DWR Levee Log, 2002 (HLM 3.96), listed as a 24-inch corrugated metal pipe (CMP). USACE San Joaquin O&M Manual, Unit 601 Part 1 (SJR 601.1), 1967, Revised 25 May 2011, (HLM 3.95), listed as a 24-inch CMP]. FS Date: 5/1/2014

View of landward side.

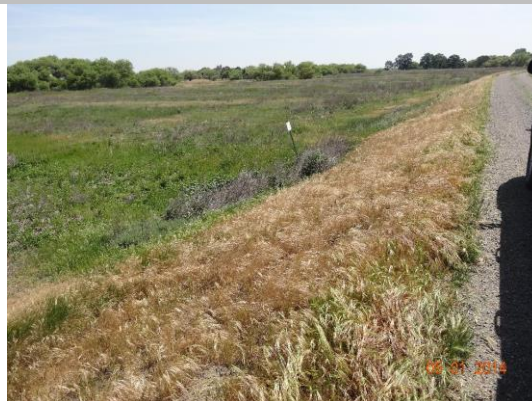
Photo 2 of 3 : UCIP\_SP\_2021\_61990\_66160.jpg

View of waterward side.

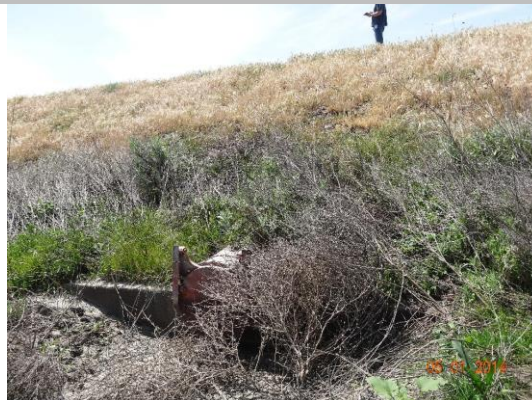
Photo 3 of 3 : UCIP\_SP\_2021\_61990\_66159.jpg

Flap gate and concrete headwall visible through dense vegetation.

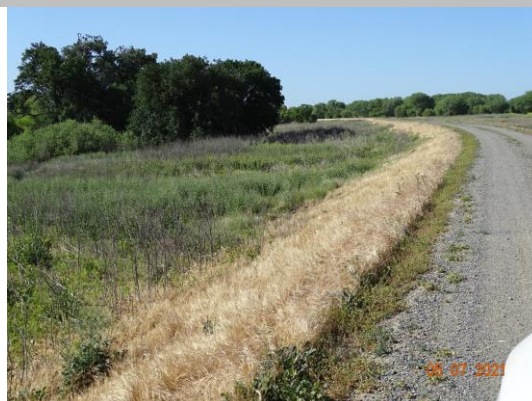
Photo 1 of 1 : SP\_2021\_NA0010\_119\_26\_20210517\_00067.jpg

LM Start	4.15	Rating **	M	Issue No.	26
LM End	7.84	Issue Type +	Ma	Location *	WS
Category	Earthen Levee			GPS Latitude/Longitude	
				Start	End
Item	Vegetation			37.277624 °	37.231535 °
				-120.832450 °	-120.812106 °
DWR ID	DWR_NA0010_02A_s_2021_26

View of vegetation on the waterside slope. (Spring 2021)

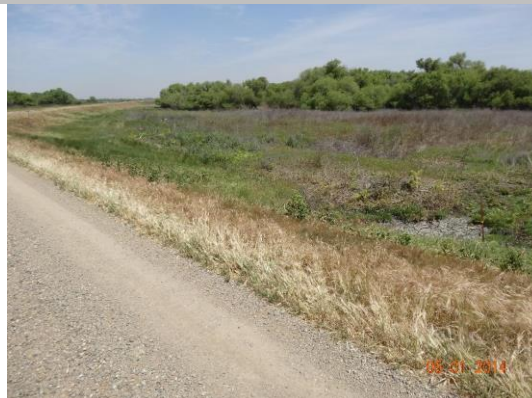
Photo 1 of 3 : UCIP\_SP\_2021\_61992\_66167.jpg

Comment Code						
Inspector Comment						
FS_ID:61992 DS_ID:19668 EP_NO: N/A Repair Type: Non-Urgent Crossing Status: Found UCIP Comments: 05/01/2014 Dense vegetation limits the inspector's visibility to identify signs of pipe failure (leaks) along the slope. Recommend removing vegetation along pipe alignment to conduct proper inspection of structure. (O. Magana - DWR UCIP) FIELD_STRUCT_DESC: 24-inch corrugated metal gravity drainage pipe through the levee, 8 feet below the crown. Flap gate on the waterside (WS) end. Brass cap No. 125 bench mark (BM) on the headwall on the landside (LS). [Additional Reference(s): DWR Levee Log, 2002 (HLM 5.45), listed as a 24-inch corrugated metal pipe (CMP). USACE San Joaquin O&M Manual, Unit 601 Part 1 (SJR 601.1), 1967, Revised 25 May 2011, (HLM 5.43), listed as a 24-inch CMP]. FS Date: 5/1/2014

View of waterward side.

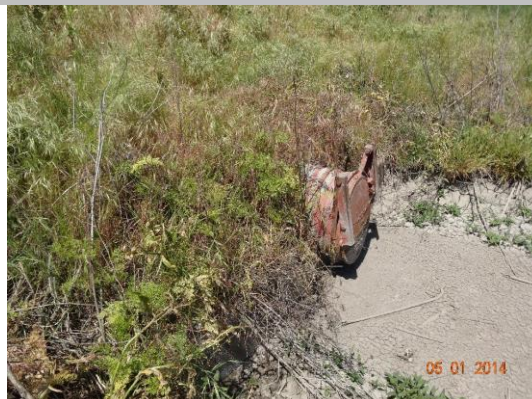
Photo 2 of 3 : UCIP\_SP\_2021\_61992\_66166.jpg

Flap gate visible on waterward side.

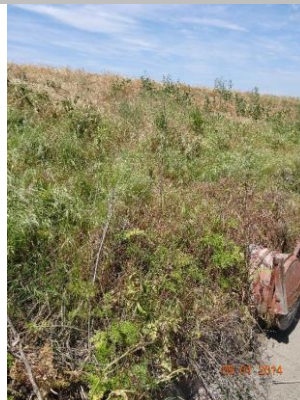
Photo 3 of 3 : UCIP\_SP\_2021\_61992\_66165.jpg

View of waterward slope covered by vegetation.

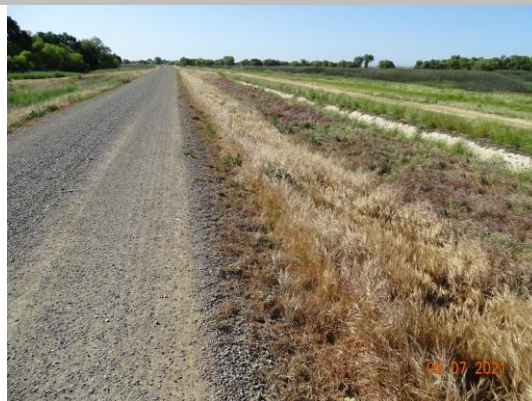
Photo 1 of 1 : SP\_2021\_NA0010\_119\_27\_20210517\_00068.jpg

LM Start	5.44	Rating **	M	Issue No.	27
LM End	7.85	Issue Type +	Ma	Location *	LS
Category	Earthen Levee			GPS Latitude/Longitude	
				Start	End
Item	Vegetation			37.259668 °	37.231492 °
				-120.831402 °	-120.812060 °
DWR ID	DWR_NA0010_02A_s_2021_27				
Comment Code					
V1 : Control annual grass and weeds on the levee slopes and easements.					
Inspector Comment

View of vegetation growing on the landside slope. (Spring 2021)

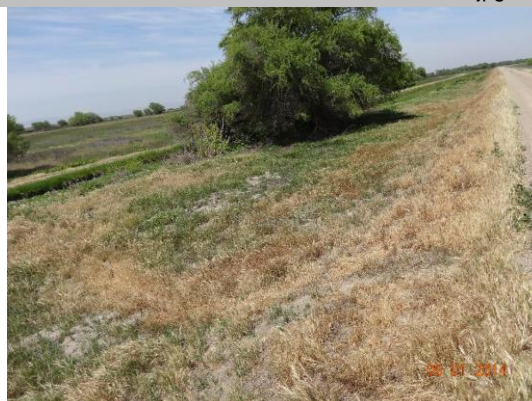
Photo 1 of 2 : UCIP\_SP\_2021\_61993\_66171.jpg

FS\_ID:61993  
DS\_ID:19669  
EP\_NO: N/A  
Repair Type: Non-Urgent  
Crossing Status: Found  
UCIP Comments: 05/01/2014 Dense vegetation limits the inspector's visibility to identify signs of pipe failure (leaks) along the slope. Recommend removing vegetation along pipe alignment to conduct proper inspection of structure. (O. Magana - DWR UCIP)  
FIELD\_STRUCT\_DESC: 24-inch corrugated metal gravity drainage pipe through the levee, 7.7 feet below the crown. Flap gate on the waterside (WS) end. Brass cap No. 125 bench mark (BM) on the headwall on the landside (LS). [Additional Reference(s): DWR Levee Log, 2002 (HLM 6.06), listed as a 24-inch corrugated metal pipe (CMP). USACE San Joaquin O&M Manual, Unit 601 Part 1 (SJR 601.1), 1967, Revised 25 May 2011, (HLM 6.06), listed as a 24-inch CMP].  
FS Date: 5/1/2014

View of landward side.

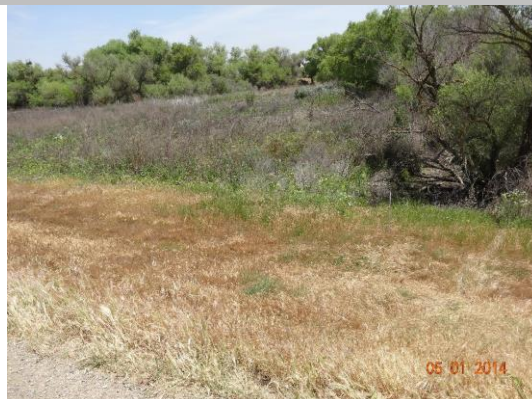
Photo 2 of 2 : UCIP\_SP\_2021\_61993\_66170.jpg

View of waterward side.

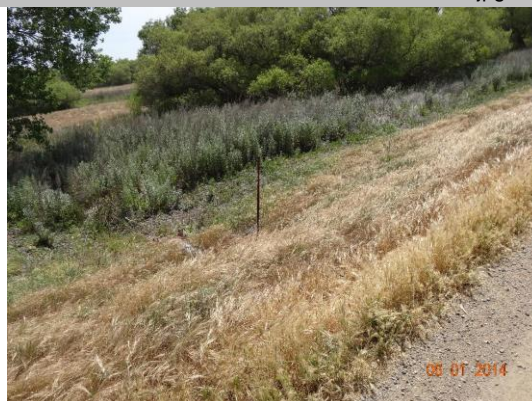
Photo 1 of 3 : UCIP\_SP\_2021\_61994\_66173.jpg

FS\_ID:61994  
DS\_ID:19670  
EP\_NO: N/A  
Repair Type: Non-Urgent  
Crossing Status: Found  
UCIP Comments: 05/01/2014 Dense vegetation limits the inspector's visibility to identify signs of pipe failure (leaks) along the slope. Recommend removing vegetation along pipe alignment to conduct proper inspection of structure. (O. Magana - DWR UCIP)  
FIELD\_STRUCT\_DESC: 24-inch corrugated metal gravity drainage pipe through the levee, 7.7 feet below the crown. Flap gate on the waterside (WS) end. Brass cap No. 125 bench mark (BM) on the headwall on the landside (LS). [Additional Reference(s): DWR Levee Log, 2002 (HLM 6.50), listed as a 24-inch corrugated metal pipe (CMP). USACE San Joaquin O&M Manual, Unit 601 Part 1 (SJR 601.1), 1967, Revised 25 May 2011, (HLM 6.50), listed as a 24-inch CMP].  
FS Date: 5/1/2014

View of waterward side.

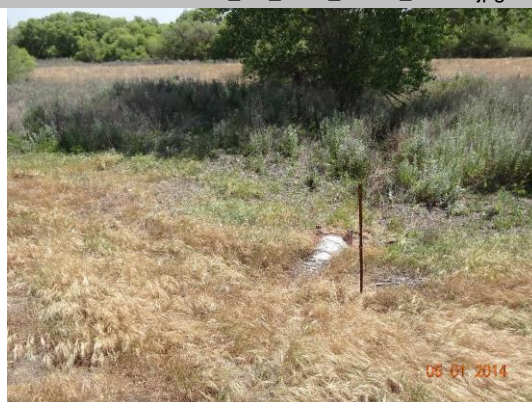
Photo 2 of 3 : UCIP\_SP\_2021\_61994\_66172.jpg

Crossing and flap gate visible on waterward side.

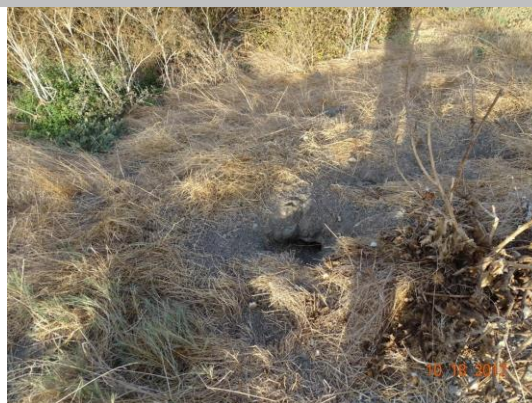
Photo 1 of 1 : SP\_2021\_NA0010\_119\_28\_20210308\_00008.jpg

LM Start	6.97	Rating **	A/W	Issue No.	28
LM End	6.97	Issue Type +	Ma	Location *	LS
Category	Earthen Levee			GPS Latitude/Longitude	
				Start	End
Item	Animal Control			37.241125 °	37.241125 °
				-120.821747 °	-120.821747 °
DWR ID	DWR_NA0010_02A_f_2017_28				
Comment Code					
A3 : No rodents visible, but rodent burrows visible; need to backfill and compact or grout burrows.					
Inspector Comment

Looking northwest at landside slope.

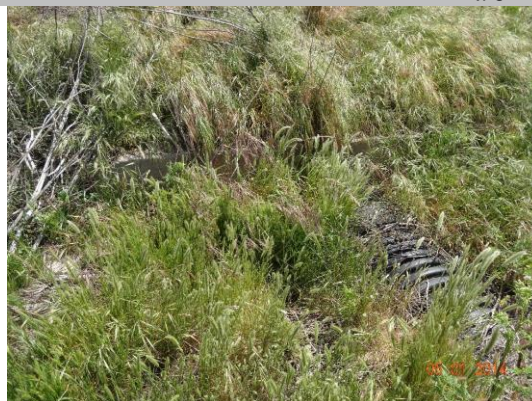
Photo 2 of 3 : UCIP\_SP\_2021\_61995\_66177.jpg

Comment Code						
Inspector Comment						
FS_ID:61995 DS_ID:19671 EP_NO: N/A Repair Type: Non-Urgent Crossing Status: Found UCIP Comments: 05/01/2014 Dense vegetation limits the inspector's visibility to identify signs of pipe failure (leaks) along the slope. Recommend removing vegetation along pipe alignment to conduct proper inspection of structure. Pipe extension visible on landward side-- need to contact owner for additional information about extension/modification. (O. Magana - DWR UCIP) FIELD_STRUCT_DESC: 24-inch corrugated metal gravity drainage pipe through the levee, 12.6 feet below the crown. Flap gate on the waterside (WS) end. Brass cap No. 125 bench mark (BM) on the headwall on the landside (LS). [Additional Reference(s): DWR Levee Log, 2002 (HLM 7.06), listed as a 24-inch corrugated metal pipe (CMP). USACE San Joaquin O&M Manual, Unit 601 Part 1 (SJR 601.1), 1967, Revised 25 May 2011, (HLM 7.05), listed as a 24-inch CMP]. FS Date: 5/1/2014

Pipe extension visible on landward side attached to inlet at concrete headwall.

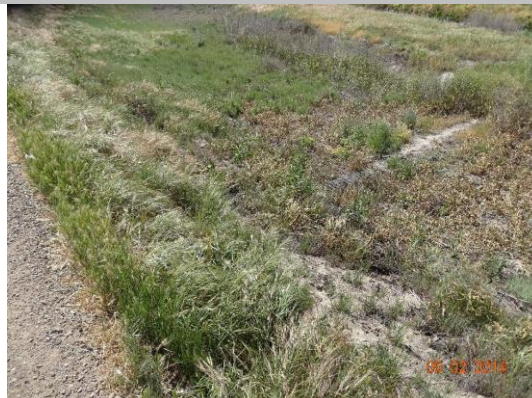
Photo 2 of 3 : UCIP\_SP\_2021\_61997\_66182.jpg

View of landward side.

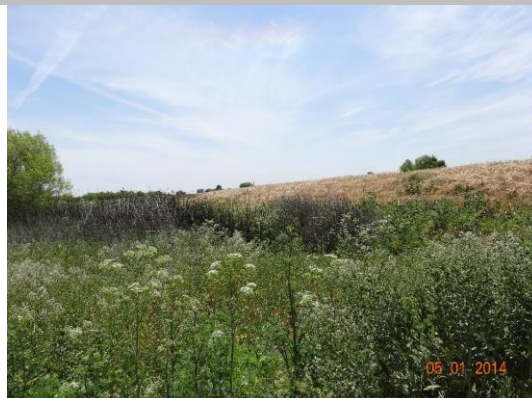
Photo 3 of 3 : UCIP\_SP\_2021\_61997\_66181.jpg

View of waterward side--photo taken from levee toe looking towards alignment of crossing.

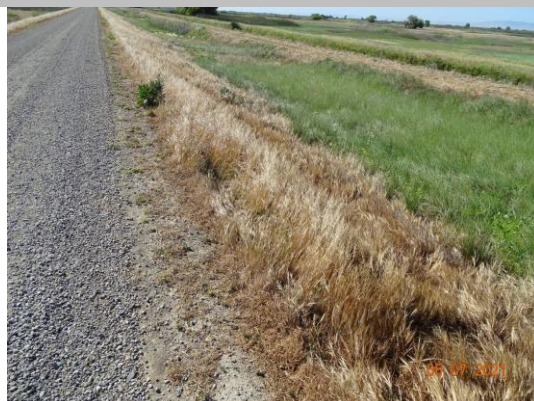
Photo 1 of 1 : SP\_2021\_NA0010\_120\_17\_20210517\_00041.jpg

LM Start	7.87	Rating **	M	Issue No.	17
LM End	9.66	Issue Type +	Ma	Location *	LS
Category	Earthen Levee			GPS Latitude/Longitude	
				Start	End
Item	Vegetation			37.231235 °	37.220367 °
				-120.811789 °	-120.784770 °
DWR ID	DWR_NA0010_02B_s_2021_17				
Comment Code					
V1 : Control annual grass and weeds on the levee slopes and easements.					
Inspector Comment

View of vegetation along the landside slope. (Spring 2021)

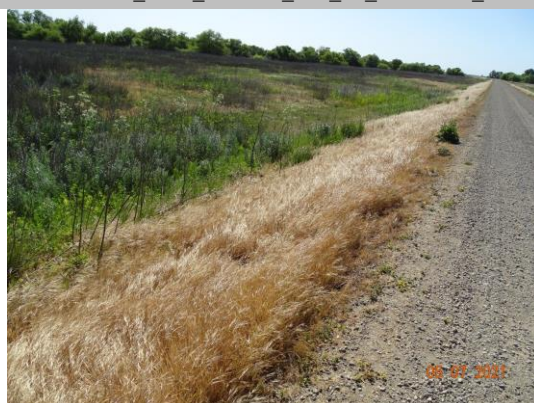
Photo 1 of 1 : SP\_2021\_NA0010\_120\_18\_20210517\_00042.jpg

LM Start	7.87	Rating **	M	Issue No.	18
LM End	12.49	Issue Type +	Ma	Location *	WS
Category	Earthen Levee			GPS Latitude/Longitude	
				Start	End
Item	Vegetation			37.231235 °	37.187663 °
				-120.811789 °	-120.766198 °
DWR ID	DWR_NA0010_02B_s_2021_18				
Comment Code					
V1 : Control annual grass and weeds on the levee slopes and easements.					
Inspector Comment

Looking upstream along the waterside slope. (Spring 2021)

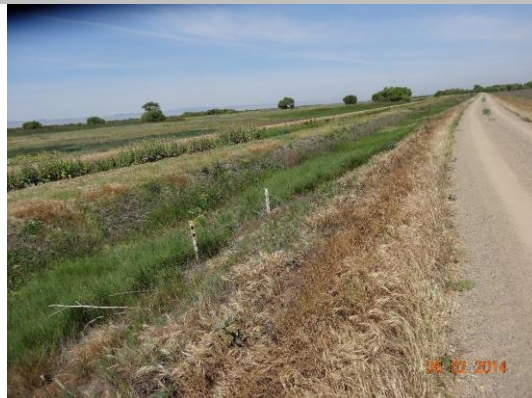
Photo 1 of 3 : UCIP\_SP\_2021\_62001\_66184.jpg

Comment Code						
Inspector Comment						
FS_ID:62001 DS_ID:19674 EP_NO: N/A Repair Type: Non-Urgent Crossing Status: Found UCIP Comments: 05/14/2014 Dense vegetation limits the inspector's visibility to identify signs of pipe failure (leaks) along the slope and landward headwall. Recommend removing vegetation along pipe alignment and toe to conduct proper inspection of structure. Sediment buildup in pipe visible from landward side--recommend clearing. (O. Magana - DWR UCIP) FIELD_STRUCT_DESC: 24-inch corrugated metal gravity drainage pipe through the levee, 9 feet below the crown. Flap gate on the waterside (WS) end. Brass cap No. 120 bench mark (BM) on the headwall on the landside (LS). [Additional Reference(s): DWR Levee Log, 2002 (HLM 8.17), listed as a 24-inch corrugated metal pipe (CMP). USACE San Joaquin O&M Manual, Unit 601 Part 1 (SJR 601.1), 1967, Revised 25 May 2011, (HLM 8.16), listed as a 24-inch CMP]. FS Date: 5/14/2014

View of landward side.

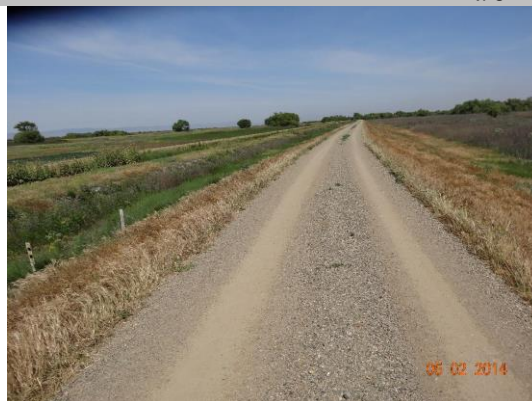
Photo 2 of 3 : UCIP\_SP\_2021\_62001\_66185.jpg

Overview of levee crown at crossing.

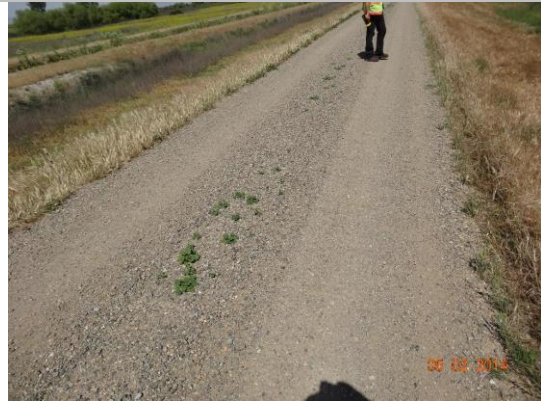
Photo 2 of 3 : UCIP\_SP\_2021\_62003\_66193.jpg

Overview of levee crown at crossing.

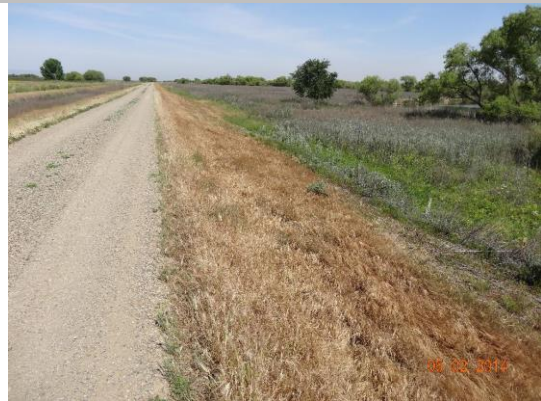
Photo 3 of 3 : UCIP\_SP\_2021\_62003\_66194.jpg

View of waterward side.

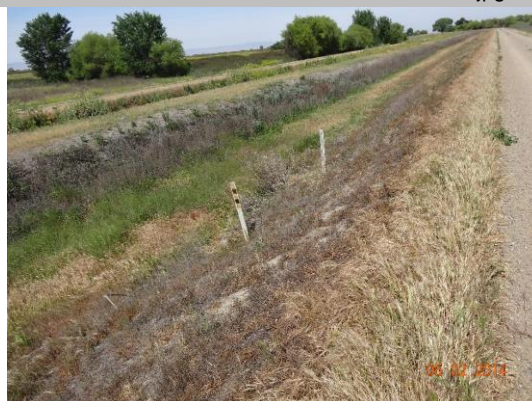
Photo 1 of 3 : UCIP\_SP\_2021\_62004\_66200.jpg

FS\_ID:62004  
DS\_ID:19676  
EP\_NO: N/A  
Repair Type: Non-Urgent  
Crossing Status: Found  
UCIP Comments: 05/14/2014 Dense vegetation limits the inspector's visibility to identify signs of pipe failure (leaks) along the slope. Recommend removing vegetation along pipe alignment to conduct proper inspection of structure. Burrow activity present on waterward slope. (O. Magana - DWR UCIP)  
FIELD\_STRUCT\_DESC: 24-inch corrugated metal gravity drainage pipe through the levee, 8.8 feet below the crown. Flap gate on the waterside (WS) end. Brass cap No. 120 bench mark (BM) on the headwall on the landside (LS). [Additional Reference(s): DWR Levee Log, 2002 (HLM 8.88), listed as a 24-inch corrugated metal pipe (CMP). USACE San Joaquin O&M Manual, Unit 601 Part 1 (SJR 601.1), 1967, Revised 25 May 2011, (recorded as HLM 9.86 should be HLM 8.86), listed as a 24-inch CMP].  
FS Date: 5/14/2014

View of landward side.

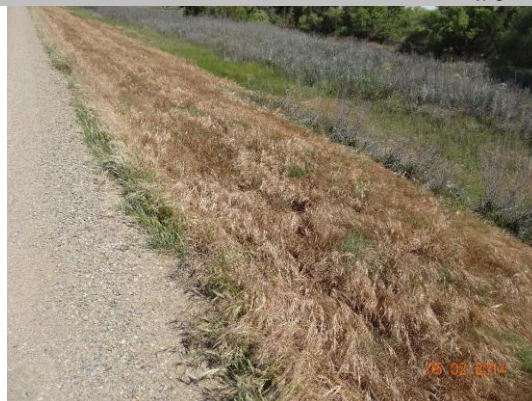
Photo 2 of 3 : UCIP\_SP\_2021\_62004\_66199.jpg

View of waterward side.

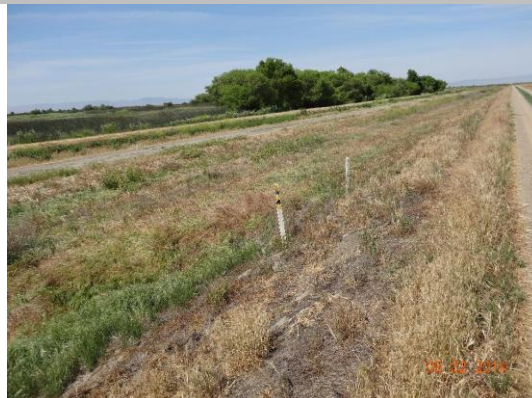
Photo 1 of 3 : UCIP\_SP\_2021\_62006\_66211.jpg

Comment Code						
Inspector Comment						
FS_ID:62006 DS_ID:19678 EP_NO: N/A Repair Type: Non-Urgent Crossing Status: Found UCIP Comments: 05/14/2014 Dense vegetation limits the inspector's visibility to identify signs of pipe failure (leaks) along the slope. Recommend removing vegetation along pipe alignment to conduct proper inspection of structure. (O. Magana - DWR UCIP) FIELD_STRUCT_DESC: 24-inch corrugated metal gravity drainage pipe through the levee, 8 feet below the crown. Flap gate on the waterside (WS) end. Brass cap No. 120 bench mark (BM) on the headwall on the landside (LS). [Additional Reference(s): DWR Levee Log, 2002 (HLM 9.21), listed as a 24-inch corrugated metal pipe (CMP). USACE San Joaquin O&M Manual, Unit 601 Part 1 (SJR 601.1), 1967, Revised 25 May 2011, (HLM 9.20), listed as a 24-inch CMP]. FS Date: 5/14/2014

View of landward side.

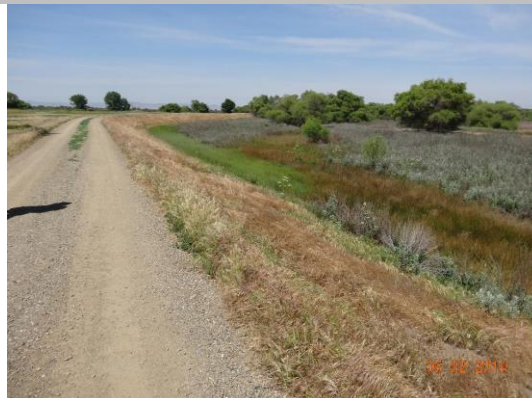
Photo 2 of 3 : UCIP\_SP\_2021\_62008\_66216.jpg

View of waterward side.

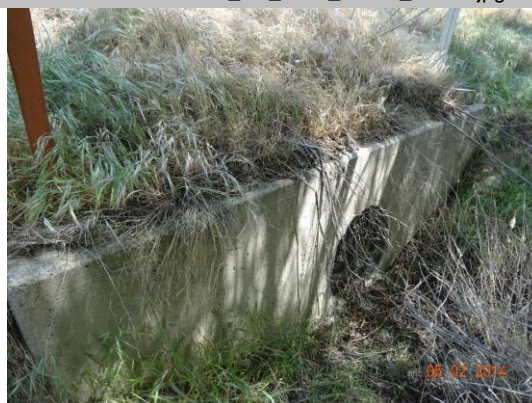
Photo 3 of 3 : UCIP\_SP\_2021\_62008\_66215.jpg

Concrete headwall visible on landward side.

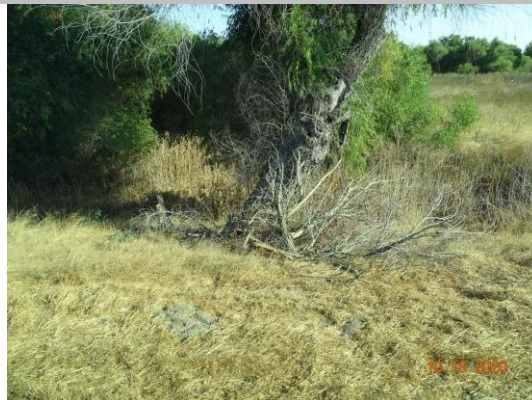
Photo 1 of 1 : SP\_2021\_NA0010\_120\_15\_20210308\_00003.jpg

LM Start	9.60	Rating **	M	Issue No.	15
LM End	9.60	Issue Type +	Ma	Location *	WS
Category	Earthen Levee			GPS Latitude/Longitude	
				Start	End
Item	Encroachments			37.220783 °	37.220783 °
				-120.785729 °	-120.785729 °
DWR ID	DWR_NA0010_02B_f_2020_15				
Comment Code					
TR : Tree or limb					
Inspector Comment					
Broken tree limbs on the waterside slope.

Tree limb on the waterside slope. (Fall 2020)

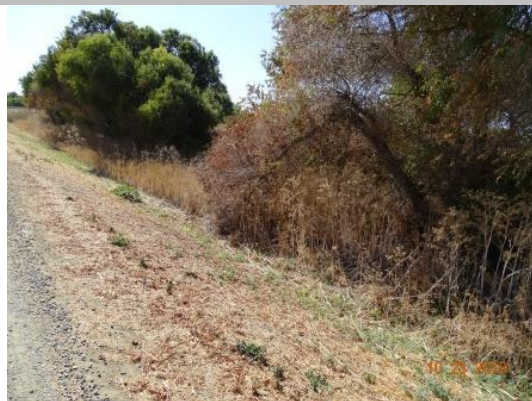
Photo 1 of 1 : SP\_2021\_NA0010\_120\_20\_20210308\_00005.jpg

LM Start	9.90	Rating **	M	Issue No.	20
LM End	9.90	Issue Type +	Ma	Location *	LS
Category	Earthen Levee			GPS Latitude/Longitude	
				Start	End
Item	Trim / Thin Trees			37.216923 °	37.216923 °
				-120.784007 °	-120.784007 °
DWR ID	DWR_NA0010_02B_f_2019_20				
Comment Code					
T1 : Trim trees to at least five feet above ground level.					
Inspector Comment					
Dead tree limb hanging on landside toe.

View of broken tree limb hanging over landside slope and toe. (Fall 2019)

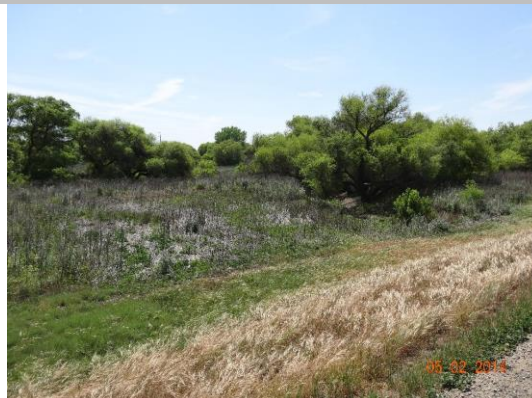
Photo 1 of 3 : UCIP\_SP\_2021\_62009\_66224.jpg

Comment Code						
Inspector Comment						
FS_ID:62009 DS_ID:19687 EP_NO: N/A Repair Type: Non-Urgent Crossing Status: Found UCIP Comments: 05/14/2014 Dense vegetation limits the inspector's visibility to identify signs of pipe failure (leaks) along the slope. Recommend removing vegetation along pipe alignment to conduct proper inspection of structure. (O. Magana - DWR UCIP) FIELD_STRUCT_DESC: 24-inch corrugated metal gravity drainage pipe through the levee, 11.7 feet below the crown. Flap gate on the waterside (WS) end. Brass cap No. 115 bench mark (BM) on the headwall on the landside (LS). [Additional Reference(s): DWR Levee Log, 2002 (HLM 10.13), listed as a 24-inch corrugated metal pipe (CMP). USACE San Joaquin O&M Manual, Unit 601 Part 1 (SJR 601.1), 1967, Revised 25 May 2011, (HLM 10.12), listed as a 24-inch CMP]. FS Date: 5/14/2014

Overview of waterward side.

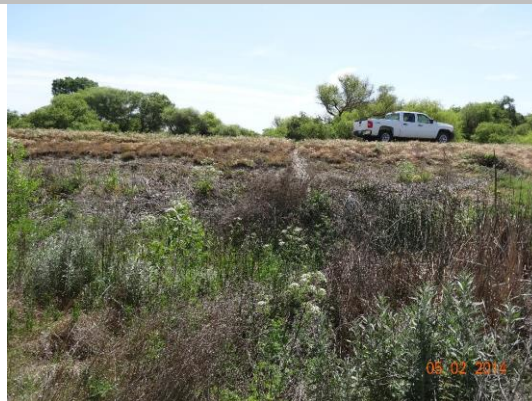
Photo 2 of 3 : UCIP\_SP\_2021\_62009\_66226.jpg

View of waterward slope.

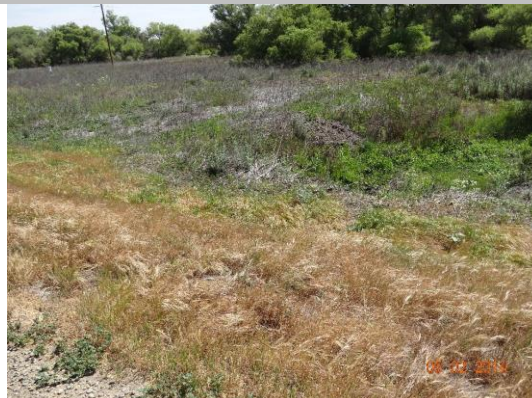
Photo 3 of 3 : UCIP\_SP\_2021\_62009\_66222.jpg

View of waterward side.

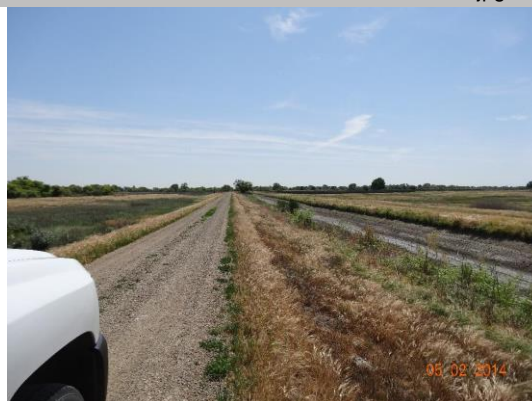
Photo 1 of 3 : UCIP\_SP\_2021\_62010\_66231.jpg

FS\_ID:62010  
 DS\_ID:19688  
 EP\_NO: N/A  
 Repair Type: Non-Urgent  
 Crossing Status: Found  
 UCIP Comments: 05/14/2014 Dense vegetation limits the inspector's visibility to identify signs of pipe failure (leaks) along the slope. Recommend removing vegetation along pipe alignment to conduct proper inspection of structure. Sediment buildup in pipe visible on landward side--recommend clearing. (O. Magana - DWR UCIP)  
 FIELD\_STRUCT\_DESC: 24-inch corrugated metal gravity drainage pipe through the levee, 8 feet below the crown. Flap gate on the waterside (WS) end. Brass cap No. 115 bench mark (BM) on the headwall on the landside (LS). [Additional Reference(s): DWR Levee Log, 2002 (HLM 10.82), listed as a 24-inch corrugated metal pipe (CMP). USACE San Joaquin O&M Manual, Unit 601 Part 1 (SJR 601.1), 1967, Revised 25 May 2011, (HLM 10.81), listed as a 24-inch CMP].  
 FS Date: 5/14/2014

View of landward side.

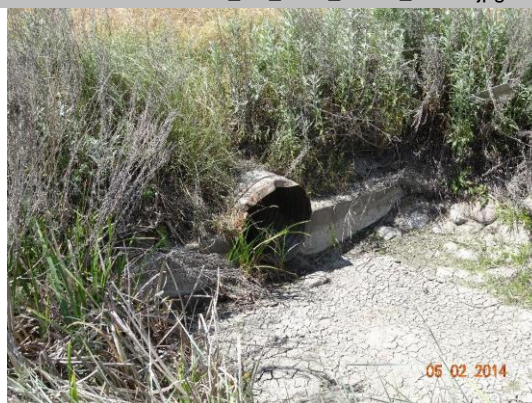
Photo 3 of 3 : UCIP\_SP\_2021\_62010\_66234.jpg

View of pipe visible on waterward side.

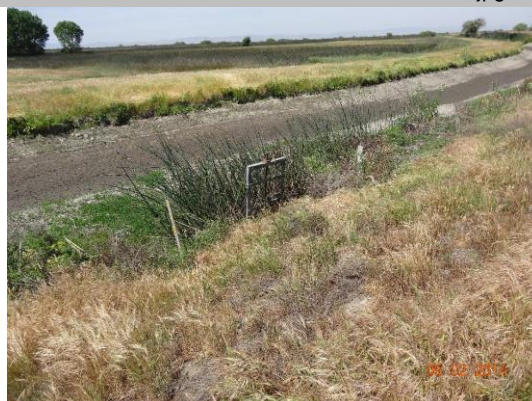
Photo 1 of 3 : UCIP\_SP\_2021\_62012\_66236.jpg

Comment Code						
Inspector Comment						
FS_ID:62012 DS_ID:19689 EP_NO: N/A Repair Type: Non-Urgent Crossing Status: Found UCIP Comments: 05/14/2014 Dense vegetation limits the inspector's visibility to identify signs of pipe failure (leaks) along the slope. Recommend removing vegetation along pipe alignment to conduct proper inspection of structure. (O. Magana - DWR UCIP) FIELD_STRUCT_DESC: 24-inch corrugated metal gravity drainage pipe through the levee, 8 feet below the crown. Flap gate on the waterside (WS) end. Brass cap No. 115 bench mark (BM) on the headwall on the landside (LS). [Additional Reference(s): DWR Levee Log, 2002 (HLM 11.18), listed as a 24-inch corrugated metal pipe (CMP). USACE San Joaquin O&M Manual, Unit 601 Part 1 (SJR 601.1), 1967, Revised 25 May 2011, (HLM 11.17), listed as a 24-inch CMP]. FS Date: 5/14/2014

View of landward slope.

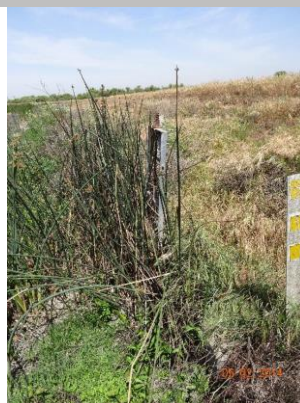
Photo 2 of 3 : UCIP\_SP\_2021\_62012\_66235.jpg

Slide gate visible on landward side blocked by vegetation.

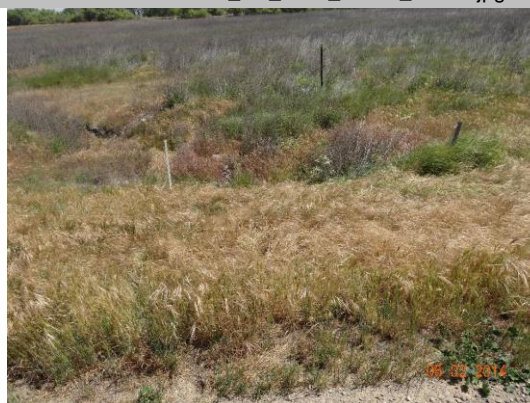
Photo 3 of 3 : UCIP\_SP\_2021\_62012\_66238.jpg

View of waterward side.

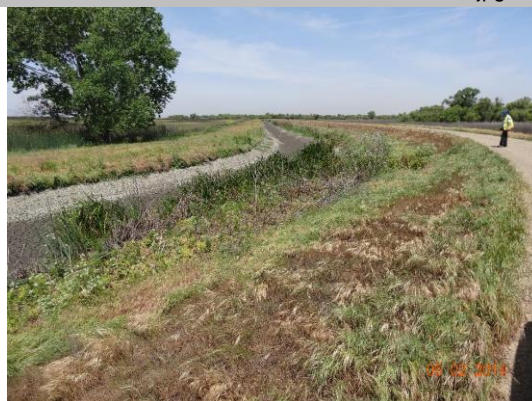
Photo 1 of 3 : UCIP\_SP\_2021\_62016\_66241.jpg

Comment Code						
Inspector Comment						
FS_ID:62016 DS_ID:19690 EP_NO: N/A Repair Type: Non-Urgent Crossing Status: Found UCIP Comments: 05/14/2014 Dense vegetation limits the inspector's visibility to identify signs of pipe failure (leaks) along the slope. Recommend removing vegetation along pipe alignment to conduct proper inspection of structure. (O. Magana - DWR UCIP) FIELD_STRUCT_DESC: 24-inch corrugated metal gravity drainage pipe through the levee, 8 feet below the crown. Flap gate on the waterside (WS) end. Screw gate on the landside (LS). [Additional Reference(s): DWR Levee Log, 2002 (HLM 11.45), listed as a 24-inch corrugated metal pipe (CMP). USACE San Joaquin O&M Manual, Unit 601 Part 1 (SJR 601.1), 1967, Revised 25 May 2011, (HLM 11.43), listed as a 24-inch CMP]. FS Date: 5/14/2014

View of landward side.

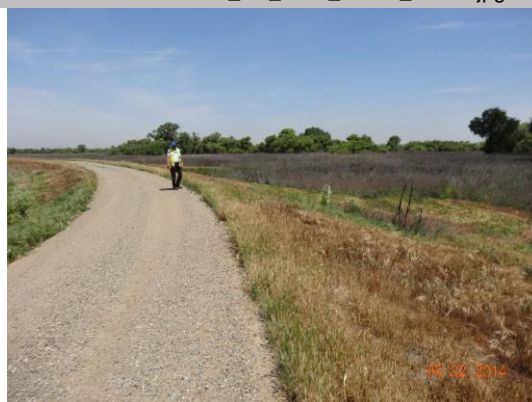
Photo 2 of 3 : UCIP\_SP\_2021\_62016\_66240.jpg

View of waterward side.

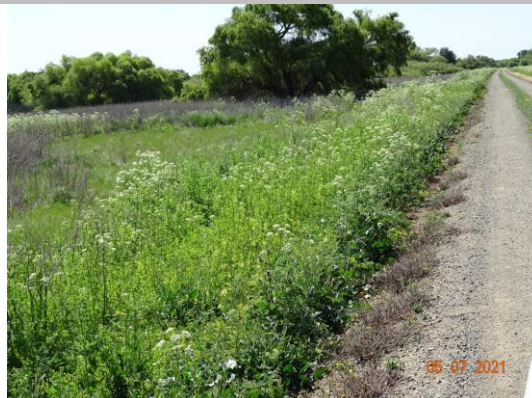
Photo 1 of 1 : SP\_2021\_NA0010\_120\_21\_20210517\_00044.jpg

LM Start	12.88	Rating **	U	Issue No.	21
LM End	13.38	Issue Type +	Ma	Location *	WS
Category	Earthen Levee			GPS Latitude/Longitude	
				Start	End
Item	Vegetation			37.183114 °	37.176860 °
				-120.767481 °	-120.762968 °
DWR ID	DWR_NA0010_02B_s_2021_21				
Comment Code					
V1 : Control annual grass and weeds on the levee slopes and easements.					
Inspector Comment

View of vegetation growing on the waterside slope. (Spring 2021)

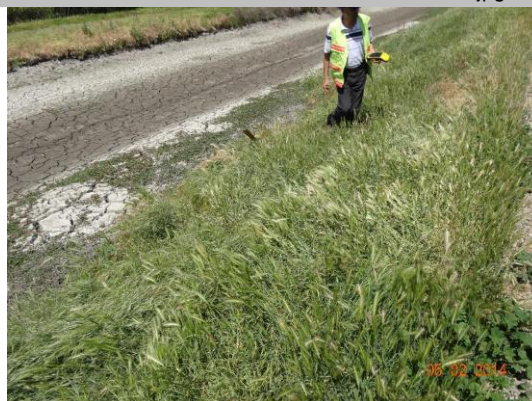
Photo 1 of 3 : UCIP\_SP\_2021\_62018\_66245.jpg

Comment Code						
Inspector Comment						
FS_ID:62018 DS_ID:19663 EP_NO: N/A Repair Type: Non-Urgent Crossing Status: Found UCIP Comments: 05/14/2014 Dense vegetation limits the inspector's visibility to identify signs of pipe failure (leaks) along the slope. Recommend removing vegetation along pipe alignment to conduct proper inspection of structure. Sediment buildup in pipe--recommend clearing. (O. Magana - DWR UCIP) FIELD_STRUCT_DESC: 24-inch corrugated metal gravity drainage pipe through the levee, 6.5 feet below the crown. Slide gate in a pipe riser on the waterside (WS) slope. [Additional Reference(s): DWR Levee Log, 2002 (HLM 13.23), listed as a 24-inch corrugated metal pipe (CMP). USACE San Joaquin O&M Manual, Unit 601 Part 1 (SJR 601.1), 1967, Revised 25 May 2011, (recorded as HLM 13.32 should be HLM 13.22), listed as a 24-inch CMP]. FS Date: 5/14/2014

View of landward side.

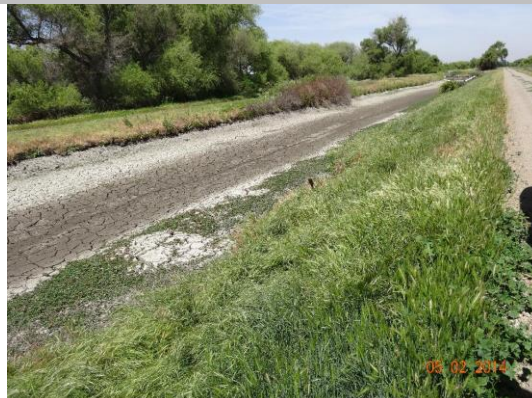
Photo 2 of 3 : UCIP\_SP\_2021\_62018\_66244.jpg

Overview of landward slope.

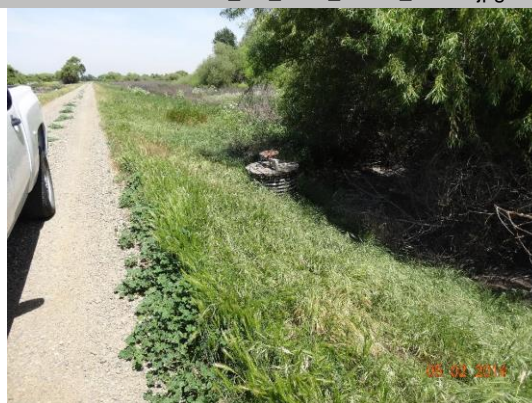
Photo 3 of 3 : UCIP\_SP\_2021\_62018\_66243.jpg

View of waterward side.

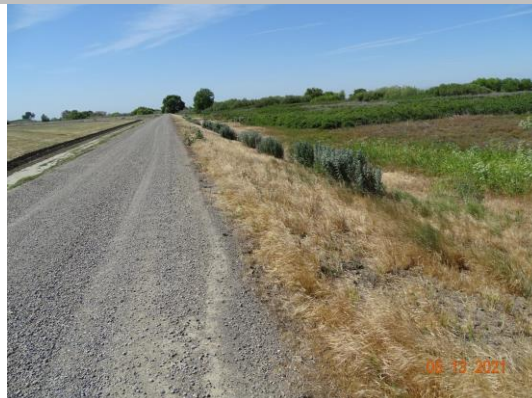
Photo 1 of 1 : SP\_2021\_NA0010\_121\_7\_20210517\_00021.jpg

LM Start	0.06	Rating **	M	Issue No.	7
LM End	0.42	Issue Type +	Ma	Location *	WS
Category	Earthen Levee			GPS Latitude/Longitude	
				Start	End
Item	Vegetation			37.110908 °	37.106145 °
				-120.587784 °	-120.585716 °
DWR ID	DWR_NA0010_03_s_2021_7				
Comment Code					
V1 : Control annual grass and weeds on the levee slopes and easements.					
Inspector Comment

View of the waterside slope looking upstream. (Spring 2021)

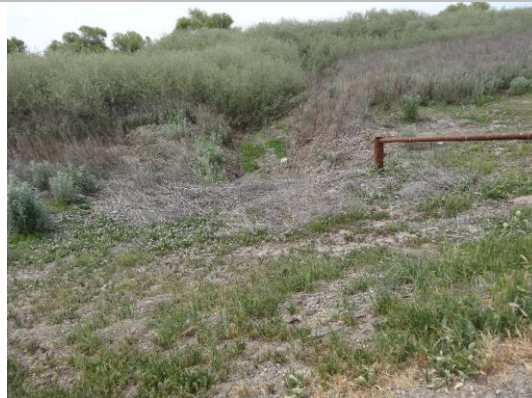
Photo 2 of 3 : UCIP\_SP\_2021\_62020\_61940.jpg

View of waterward side.

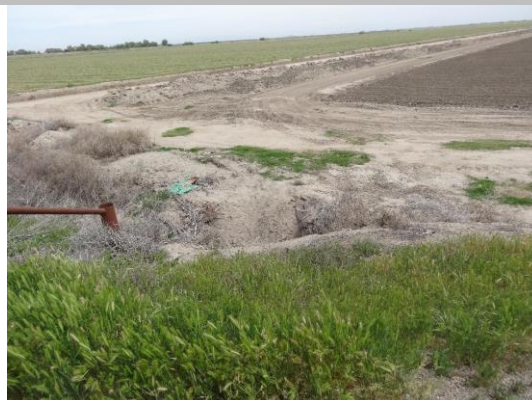
Photo 3 of 3 : UCIP\_SP\_2021\_62020\_61944.jpg

View of landward side.

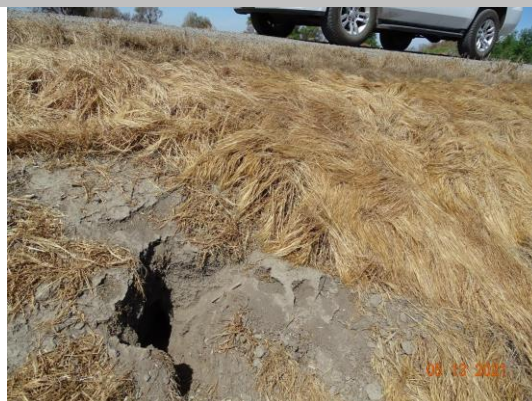
Photo 1 of 1 : SP\_2021\_NA0010\_121\_10\_20210517\_00023.jpg

LM Start	0.57	Rating **	U	Issue No.	10
LM End	0.57	Issue Type +	Ma	Location *	LS
Category	Earthen Levee			GPS Latitude/Longitude	
				Start	End
Item	Animal Control			37.104343 °	37.104343 °
				-120.584348 °	-120.584348 °
DWR ID	DWR_NA0010_03_s_2021_10				
Comment Code					
A3 : No rodents visible, but rodent burrows visible; need to backfill and compact or grout burrows.					
Inspector Comment

Several large rodent burrows observed at this location. (Spring 2021)

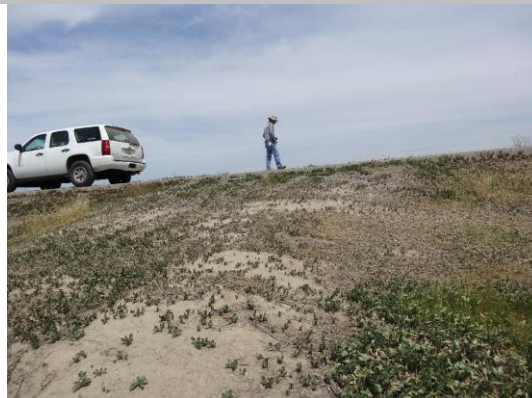
Photo 1 of 3 : UCIP\_SP\_2021\_62022\_66248.jpg

LM Start	0.76	Rating **	A/W	Issue No.	2	
LM End	0.76	Issue Type +	Ma	Location *		
Category	Supplemental			GPS Latitude/Longitude		
				Start		End
Item	DWR UCIP LMA Responsibility			37.102964 °		37.102964 °
				-120.581421 °		-120.581421 °
DWR ID	19692					
Comment Code						
Inspector Comment						
FS_ID:62022 DS_ID:19692 EP_NO: N/A Repair Type: No Action Needed Crossing Status: Found UCIP Comments: FIELD_STRUCT_DESC: 24-inch corrugated metal gravity drainage pipe through the levee, 9.3 feet below the crown. Flap gate on the waterside (WS) end. [Additional Reference(s): DWR Levee Log, 2002 (HLM 0.78), listed as a 24-inch corrugated metal pipe (CMP). USACE San Joaquin O&M Manual, Unit 601 Part 1 (SJR 601.1), 1967, Revised 25 May 2011, (HLM 0.77), listed as a 24-inch CMP]. FS Date: 4/17/2014

View of waterward slope.

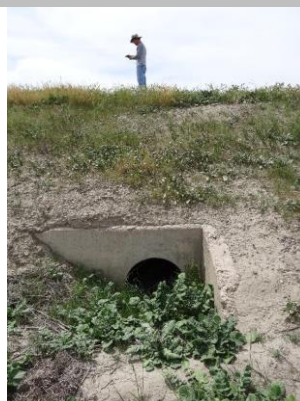
Photo 3 of 3 : UCIP\_SP\_2021\_62022\_66251.jpg

View of landward slope.

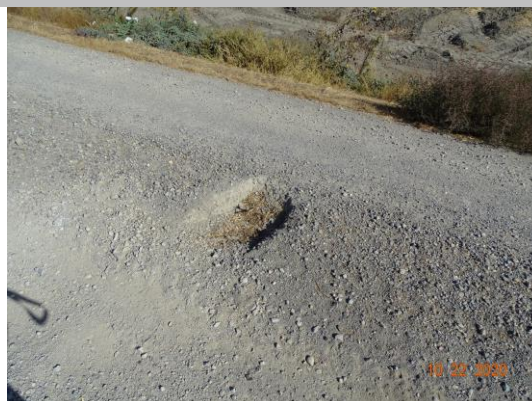
Photo 1 of 1 : SP\_2021\_NA0010\_121\_8\_20210308\_00004.jpg

LM Start	0.86	Rating **	M	Issue No.	8
LM End	0.86	Issue Type +	Ma	Location *	CR
Category	Earthen Levee			GPS Latitude/Longitude	
				Start	End
Item	Animal Control			37.101821 °	37.101821 °
				-120.580358 °	-120.580358 °
DWR ID	DWR_NA0010_03_f_2020_8				
Comment Code					
A3 : No rodents visible, but rodent burrows visible; need to backfill and compact or grout burrows.					
Inspector Comment

Depression in the levee crown from rodent activity. (Fall 2020)

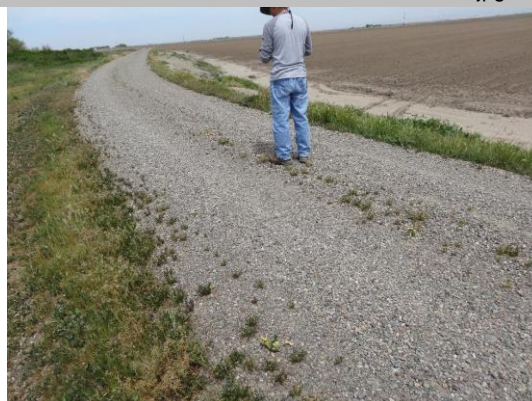
Photo 1 of 3 : UCIP\_SP\_2021\_62023\_66252.jpg

Comment Code						
Inspector Comment						
FS_ID:62023						
DS_ID:19693						
EP_NO: N/A						
Repair Type: Non-Urgent						
Crossing Status: Found						
UCIP Comments: 04/17/2014 Sediment buildup in pipe visible from landward side--recommend clearing. (O. Magana - DWR UCIP)						
FIELD_STRUCT_DESC: 24-inch corrugated metal gravity drainage pipe through the levee, 6.8 feet below the crown. Flap gate on the waterside (WS) end. [Additional Reference(s): DWR Levee Log, 2002 (HLM 1.73), listed as a 24-inch corrugated metal pipe (CMP). USACE San Joaquin O&M Manual, Unit 601 Part 1 (SJR 601.1), 1967, Revised 25 May 2011, (HLM 1.72), listed as a 24-inch CMP].						
FS Date: 4/17/2014

View of levee crown at crossing.

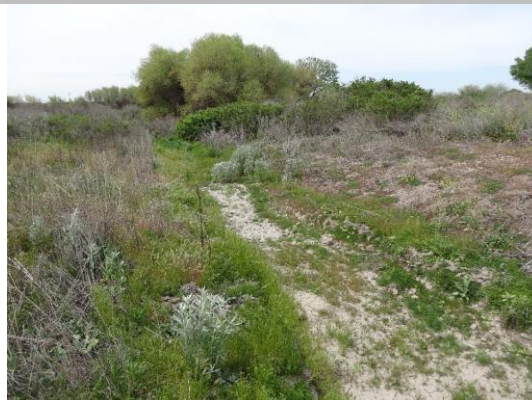
Photo 3 of 3 : UCIP\_SP\_2021\_62023\_66253.jpg

View of waterward side--channel.

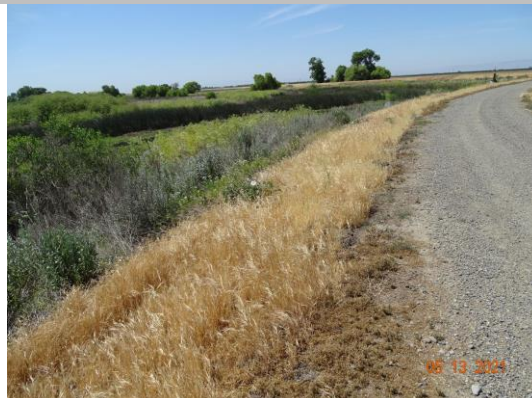
Photo 1 of 1 : SP\_2021\_NA0010\_122\_8\_20210517\_00022.jpg

LM Start	0.05	Rating **	M	Issue No.	8
LM End	0.63	Issue Type +	Ma	Location *	WS
Category	Earthen Levee			GPS Latitude/Longitude	
				Start	End
Item	Vegetation			37.112213 °	37.105084 °
				-120.589838 °	-120.587800 °
DWR ID	DWR_NA0010_04_s_2021_8				
Comment Code					
V1 : Control annual grass and weeds on the levee slopes and easements.					
Inspector Comment

View of vegetation on the waterside slope looking upstream. (Spring 2021)

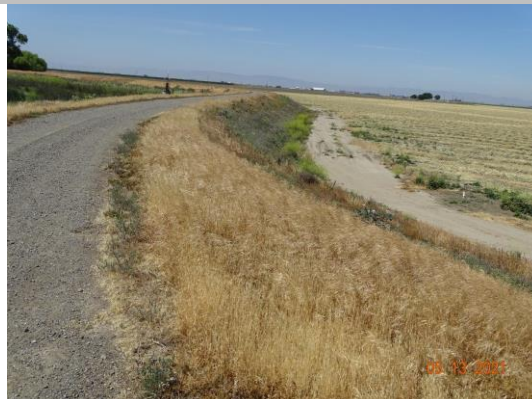
Photo 1 of 1 : SP\_2021\_NA0010\_122\_9\_20210517\_00023.jpg

LM Start	0.07	Rating **	M	Issue No.	9
LM End	0.32	Issue Type +	Ma	Location *	LS
Category	Earthen Levee			GPS Latitude/Longitude	
				Start	End
Item	Vegetation			37.112055 °	37.108774 °
				-120.589978 °	-120.590728 °
DWR ID	DWR_NA0010_04_s_2021_9				
Comment Code					
V1 : Control annual grass and weeds on the levee slopes and easements.					
Inspector Comment

View of the landside slope looking upstream. (Spring 2021)

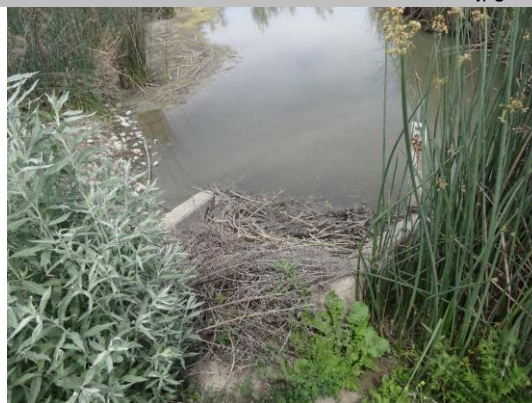
Photo 1 of 3 : UCIP\_SP\_2021\_62029\_61982.jpg

FS\_ID:62029  
DS\_ID:19695  
EP\_NO: N/A  
Repair Type: Non-Urgent  
Crossing Status: Found  
UCIP Comments: 04/17/2014 Sediment and debris blocking concrete headwall located on waterward side. During inspection water was flowing from landward side to waterward side. Recommend removing sediment to confirm condition of flap gate and pipe. (O. Magana - DWR UCIP)  
FIELD\_STRUCT\_DESC: 36-inch corrugated metal gravity drainage pipe through the levee, 18 feet below the crown. Flap gate on the waterside (WS) end. Concrete headwall on each end. [Additional Reference(s): DWR Levee Log, 2002[Additional Resource(s): DWR Levee Log, 2002 (HLM 0.03), listed as four 6-foot by 5-foot concrete culverts] (HLM 0.24), listed as a 36-inch corrugated metal pipe (CMP). USACE San Joaquin O&M Manual, Unit 601 Part 1 (SJR 601.1), 1967, Revised 25 May 2011, (HLM 0.27), listed as a 36-inch CMP].  
FS Date: 4/17/2014

View of dense vegetation near concrete headwall located on waterward side.

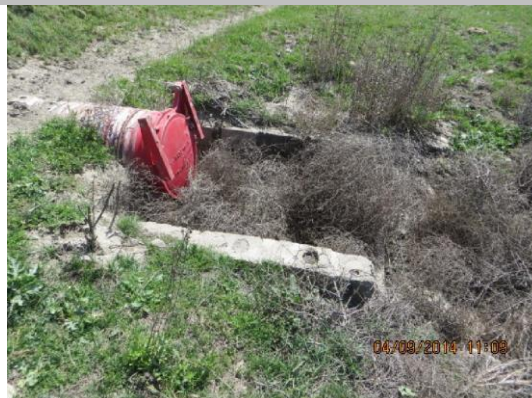
LM Start	<b>3.13</b>	Rating **	M	Issue No.	<b>21</b>
LM End	<b>3.13</b>	Issue Type +	Ma	Location *	
Category	Supplemental		GPS Latitude/Longitude		
			Start	End	
Item	DWR UCIP LMA Responsibility		37.321444 °	37.321444 °	
			-120.928764 °	-120.928764 °	
DWR ID	19574

Inspector Comment

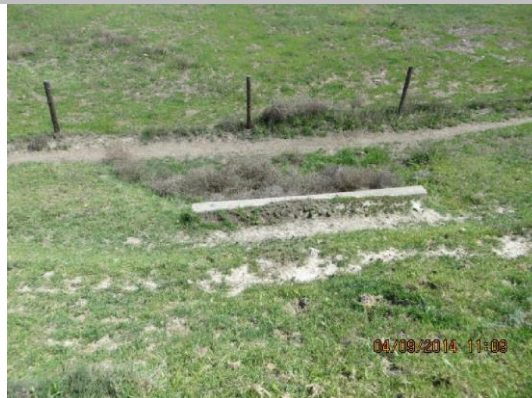
Photo 2 of 3 : UCIP\_SP\_2021\_62627\_60700.jpg

Pipe, Flapgate, and headwall on WS toe.

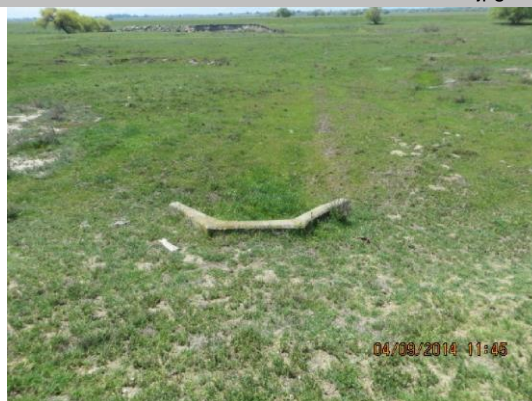
Waterway	Bank	Unit Miles	Inspection Start/End	Inspector
Unit No. 01 San Joaquin River	Right	22.52	05/04/2021 05/04/2021	Corey Fujitani

### Lower San Joaquin Levee District

Comment Code						
Inspector Comment						
FS_ID:62621 DS_ID:19575 EP_NO: N/A Repair Type: Urgent Crossing Status: Found UCIP Comments: 10/06/2020 Pipe status is still Urgent. Sinkhole present directly above LS toe headwall along pipe alignment. Pipe collapse visible from LS toe. No permit was found authorizing this encroachment. CVFPB will need to review crossing to determine owner. DWR DMP has not completed an internal inspection of the pipe but is scheduled for 2021. (B. Singh - GEI, O. Magana - DWR UCIP)11/01/2018 Pipe continues to rust through, causing the pipe to collapse on the LS. Sediment buildup visible from the LS inlet. Loss of soil just above the LS concrete headwall and along the LS slope. Crossing remains Urgent due to the levee slope issues and pipe failure through the levee. (O. Magana - DWR UCIP)07/19/2016 Same as previous inspection. Erosion present on LS slope. (O. Magana - DWR UCIP)04/08/2014 Pipe rusted through at Springline on LS toe. Flapgate blocked by sediment on WS toe. Heavy sediment on both ends of pipe. Need to contact owner to address issues. (W. Wylie - DWR UCIP) FIELD_STRUCT_DESC: 36-inch corrugated metal gravity drainage pipe through the levee, 9.7 feet below the crown. Flap gate on the waterside (WS) end. Brass cap No. 100 bench mark (BM) on the headwall on the landside (LS). [Additional Reference(s): DWR Levee Log, 2002 (HLM 3.50), listed as a 36-inch corrugated metal pipe (CMP). USACE San Joaquin O&M Manual, Unit 601 Part 1 (SJR601.1), 1967, Revised 25 May 2011, (HLM 3.50), listed as a 36-inch CMP]. FS Date: 10/6/2020

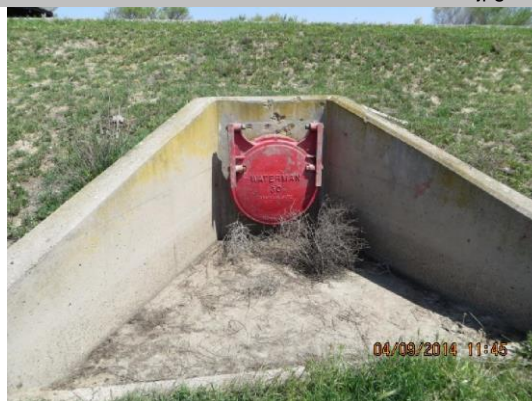
Pipe and headwall on LS toe.

Photo 3 of 3 : UCIP\_SP\_2021\_62621\_60705.jpg

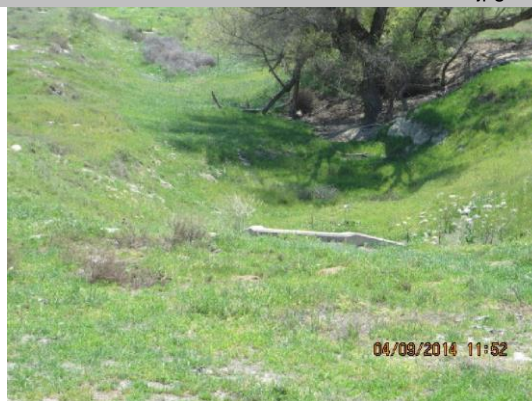
LM Start	<b>4.13</b>	Rating **	M	Issue No.	<b>29 (cont)</b>
LM End	<b>4.13</b>	Issue Type +	Ma	Location *

FS\_ID:62651  
DS\_ID:19607  
EP\_NO: N/A  
Repair Type: Non-Urgent  
Crossing Status: Found  
UCIP Comments: 10/20/2020 Barbed wire inhibiting access to pipe at LS toe. Unpermitted modifications made to structure. Recommend new DSID and removal for seemingly abandoned 12" metal pipe through levee, approximately 1 foot below crown at CLM 4.131. Visible at LS structure. Recommend DMP inspection. No permit was found authorizing these encroachments. CVFPB will need to review crossing to determine owner(s). (B. Singh - GEI, O. Magana - DWR UCIP)04/08/2014 Pipe appears sleeved with a 12-inch steel pipe with a slide gate at the LS toe. No identified authorization for changes to this crossing. Need to contact owner to obtain additional information about the modifications to crossing. (W. Wylie - DWR UCIP)  
FIELD\_STRUCT\_DESC: 48-inch corrugated metal gravity drainage pipe through the levee, 14 feet below the crown. Flap gate on the waterside (WS) end. Brass cap No. 90 bench mark (BM) on the headwall on the landside (LS). [Additional Reference(s): DWR Levee Log, 2002 (HLM 4.16), listed as a 48-inch pipe. USACE San Joaquin O&M Manual, Unit 601 Part 1 (SJR601.1), 1967, Revised 25 May 2011, (HLM 4.16), listed as a 48-inch corrugated metal pipe (CMP)].

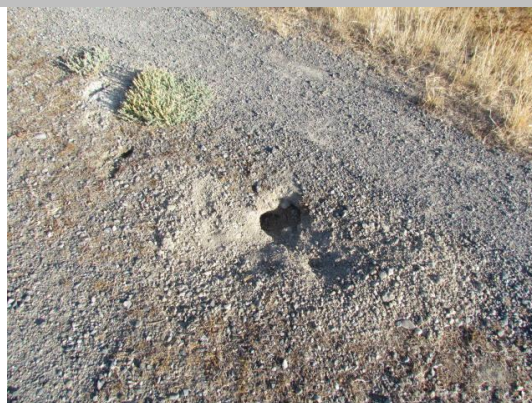
LM Start	4.69	Rating **	U	Issue No.	32 (cont)
LM End	4.69	Issue Type +	Ma	Location *	
Category	Supplemental			GPS Latitude/Longitude	
				Start	End
Item	DWR UCIP LMA Responsibility			37.302408 °	37.302408 °
				-120.920931 °	-120.920931 °
DWR ID	19609

Waterway	Bank	Unit Miles	Inspection Start/End	Inspector
Unit No. 01 San Joaquin River	Right	22.52	05/04/2021 05/04/2021	Corey Fujitani

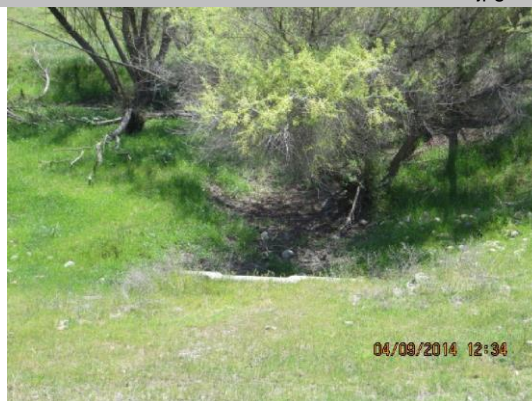
### Lower San Joaquin Levee District

**Flood Control Project Maintenance  
Levee Inspections**

LM Start	<b>5.02</b>	Rating **	M	Issue No.	<b>33</b>
LM End	<b>5.02</b>	Issue Type +	Ma	Location *	
Category	Supplemental		GPS Latitude/Longitude		
			Start	End	
Item	DWR UCIP LMA Responsibility		37.298917 °	37.298917 °	
			-120.917262 °	-120.917262 °	
DWR ID	19610
