**Flood Control Project Maintenance  
Levee Inspections**

## Maintenance Issue Types Only, Levee Inspection Report By Mile - Spring 2021

### Lower San Joaquin Levee District

Waterway	Bank	Unit Miles	Inspection Start/End	Inspector
Unit No. 01 San Joaquin River	Right	22.52	05/04/2021 05/04/2021	Corey Fujitani

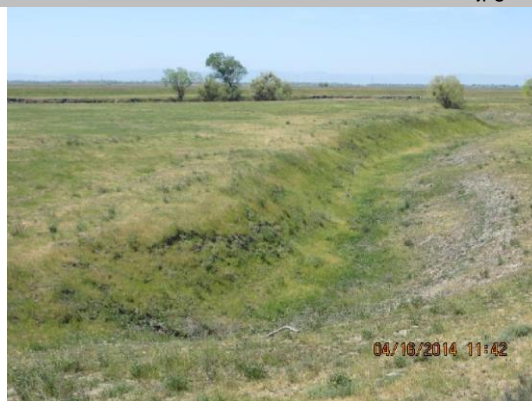
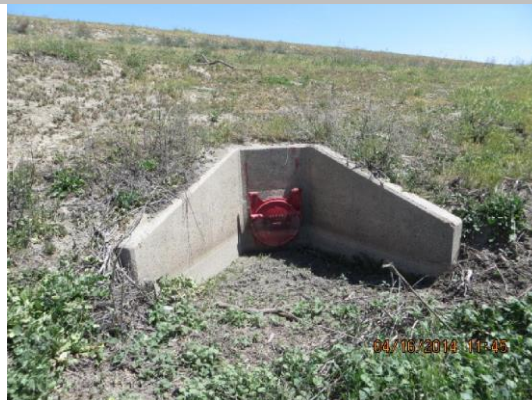
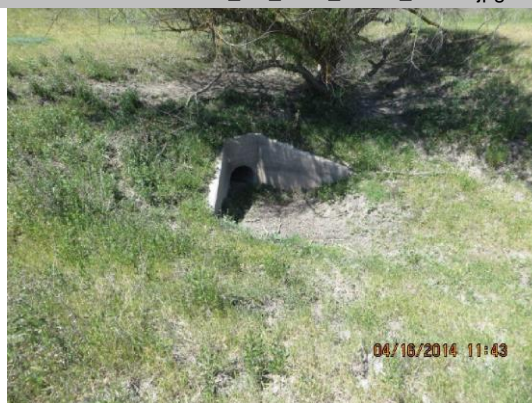
FS\_ID:62431  
DS\_ID:19769  
EP\_NO: N/A  
Repair Type: Non-Urgent  
Crossing Status: Found  
UCIP Comments: 04/16/2014 Sediment buildup in pipe visible from landward side--recommend contacting owner to clear pipe. (W. Wylie - DWR UCIP)  
FIELD\_STRUCT\_DESC: 24-inch corrugated metal gravity drainage pipe through the levee, 16 feet below the crown. Flap gate on the waterside (WS) end. Concrete U-shaped headwall on each end.  
[Additional Reference(s): DWR Levee Log, 2002 (HLM 4.01), listed as a 24-inch corrugated metal pipe (CMP). USACE San Joaquin O&M Manual, Unit 601 Part 1 (SJR601.1), 1967, Revised 25 May 2011, (HLM 4.02), listed as a 24-inch CMP]  
FS Date: 4/16/2014

Pipe, headwall, and flapgate on WS toe.

Pipe and headwall on LS toe.

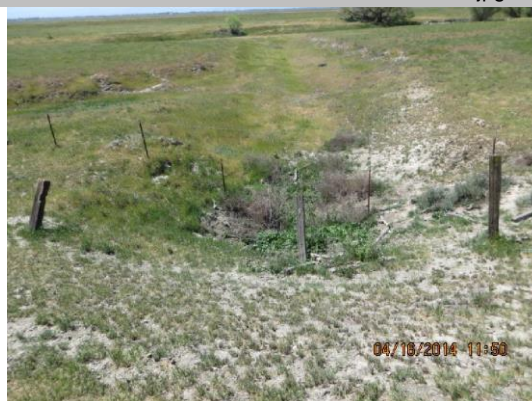
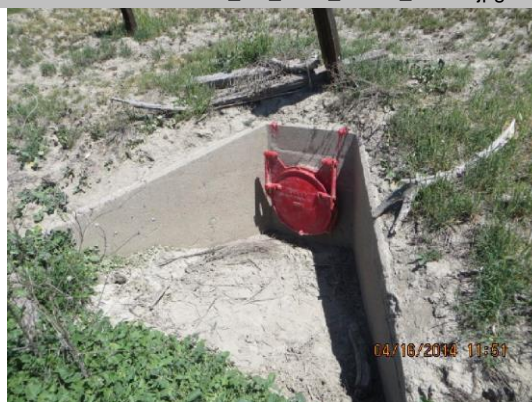
Comment Code					
Inspector Comment					
FS_ID:62432					
DS_ID:19770					
EP_NO: N/A					
Repair Type: Non-Urgent					
Crossing Status: Found					
UCIP Comments: 04/16/2014 Sediment buildup in pipe visible from landward side--recommend contacting owner to clear pipe. (W. Wylie - DWR UCIP)					
FIELD_STRUCT_DESC: 24-inch corrugated metal gravity drainage pipe through the levee, 11.6 feet below the crown. Flap gate on the waterside (WS) end. Concrete headwall on the landside (LS) end. Concrete U-shaped headwall on the WS end. [Additional Reference(s): DWR Levee Log, 2002 (HLM 4.27), listed as a 24-inch corrugated metal pipe (CMP). USACE San Joaquin O&M Manual, Unit 601 Part 1 (SJR601.1), 1967, Revised 25 May 2011, (HLM 4.27), listed as a 24-inch CMP]					
FS Date: 4/16/2014

Pipe, headwall, and flapgate on WS toe.

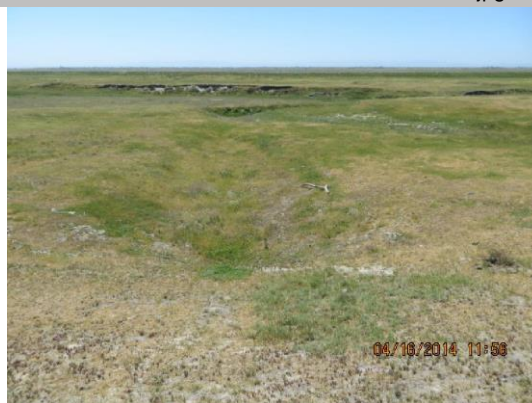
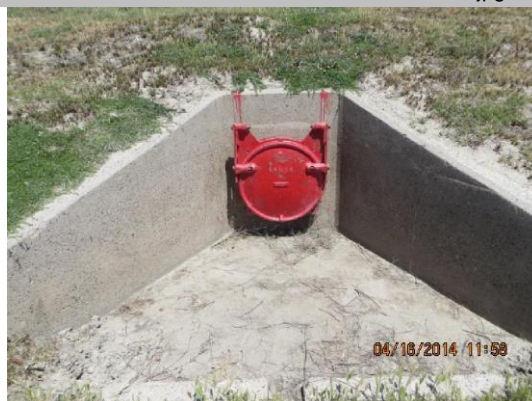
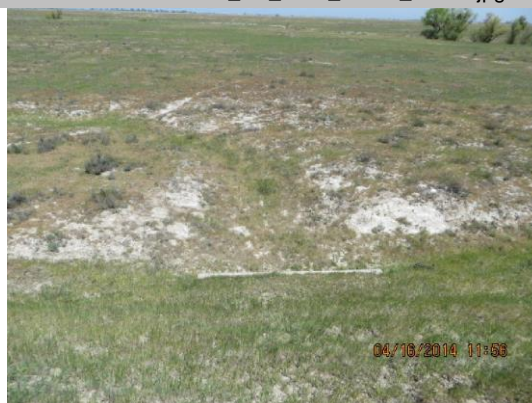
Comment Code					
Inspector Comment					
FS_ID:62433 DS_ID:19771 EP_NO: N/A Repair Type: Non-Urgent Crossing Status: Found UCIP Comments: 04/16/2014 Sediment buildup in pipe visible from landward side--recommend contacting owner to clear pipe. (W. Wylie - DWR UCIP) FIELD_STRUCT_DESC: 24-inch corrugated metal gravity drainage pipe through the levee, 12 feet below the crown. Flap gate on the waterside (WS) end. Concrete headwall on the landside (LS) end. Concrete U-shaped headwall on the WS end. [Additional Reference(s): DWR Levee Log, 2002 (HLM 4.53), listed as a 24-inch corrugated metal pipe (CMP). USACE San Joaquin O&M Manual, Unit 601 Part 1 (SJR601.1), 1967, Revised 25 May 2011, (HLM 4.54), listed as a 24-inch CMP] FS Date: 4/16/2014 8:16:00 AM

Pipe, flapgate, and headwall on WS toe.

Pipe and headwall on LS toe.

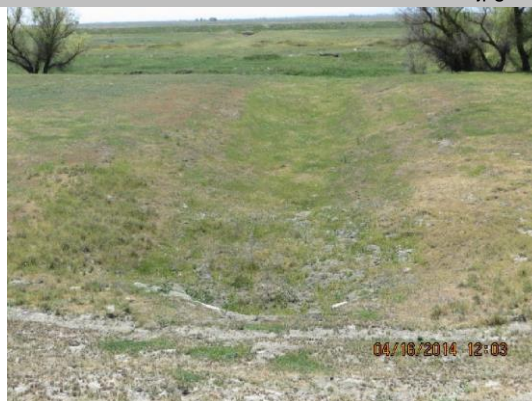
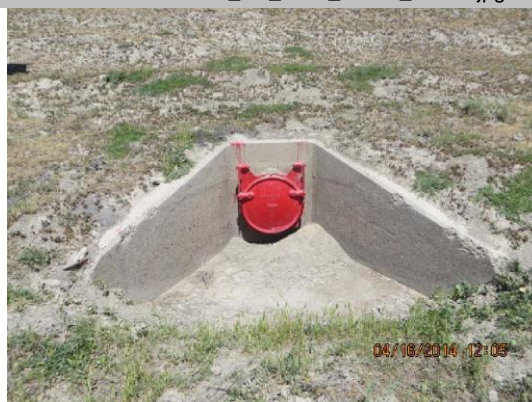
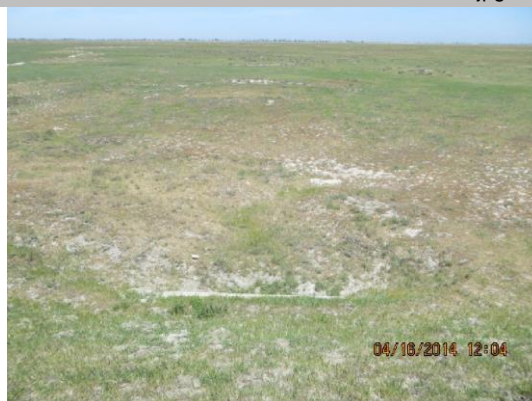
Comment Code					
Inspector Comment					
FS_ID:62434 DS_ID:19772 EP_NO: N/A Repair Type: Non-Urgent Crossing Status: Found UCIP Comments: 04/16/2014 Heavy sediment buildup in pipe visible from landward side--recommend contacting owner to clear pipe. (W. Wylie - DWR UCIP) FIELD_STRUCT_DESC: 24-inch corrugated metal gravity drainage pipe through the levee, 12.3 feet below the crown. Flap gate on the waterside (WS) end. Concrete headwall on the landside (LS) end. Concrete U-shaped headwall on the WS end. [Additional Reference(s): DWR Levee Log, 2002 (HLM 4.89), listed as a 24-inch corrugated metal pipe (CMP). USACE San Joaquin O&M Manual, Unit 601 Part 1 (SJR601.1), 1967, Revised 25 May 2011, (HLM 4.89), listed as a 24-inch CMP] FS Date: 4/16/2014

Headwall, flapgate, and pipe on WS toe.

Headwall and pipe on LS toe.

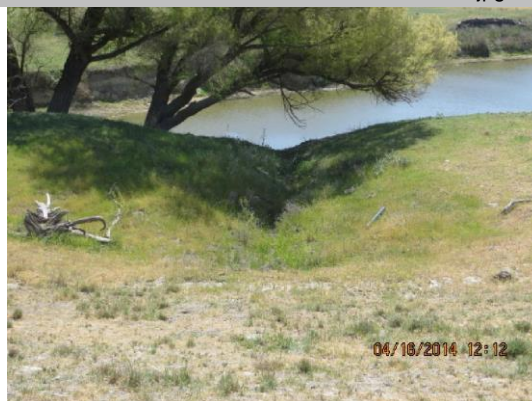
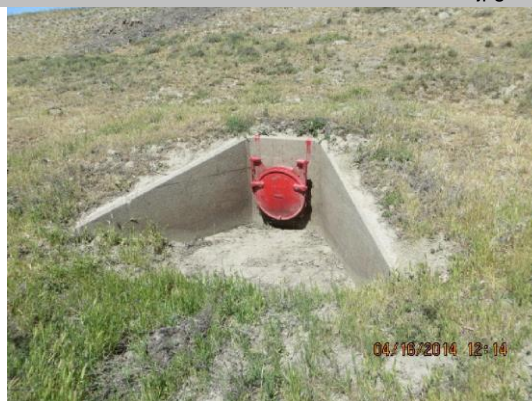
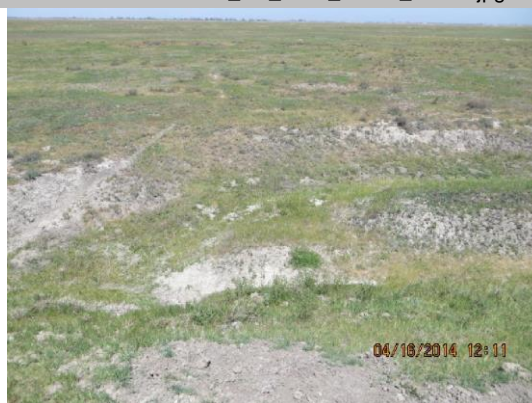
FS\_ID:62435  
DS\_ID:19773  
EP\_NO: N/A  
Repair Type: Non-Urgent  
Crossing Status: Found  
UCIP Comments: 04/16/2014 Heavy sediment buildup in pipe visible from landward side--recommend contacting owner to clear pipe. (W. Wylie - DWR UCIP)  
FIELD\_STRUCT\_DESC: 24-inch corrugated metal gravity drainage pipe through the levee, 12.2 feet below the crown. Flap gate on the waterside (WS) end. Concrete headwall on the landside (LS) end. Concrete U-shaped headwall on the WS end. [Additional Reference(s): DWR Levee Log, 2002 (HLM 5.14), listed as a 24-inch corrugated metal pipe (CMP). USACE San Joaquin O&M Manual, Unit 601 Part 1 (SJR601.1), 1967, Revised 25 May 2011, (HLM 5.15), listed as a 24-inch CMP]  
FS Date: 4/16/2014

Headwall, flapgate, and pipe on WS toe.

Headwall and pipe on LS toe.

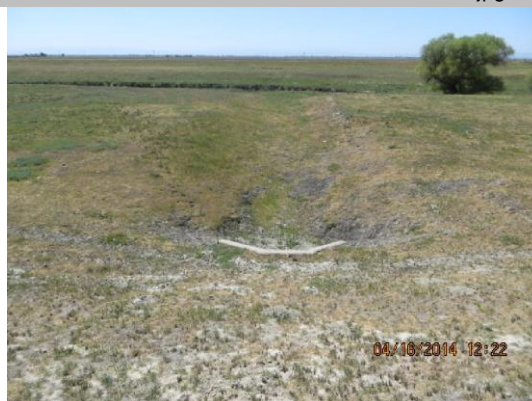
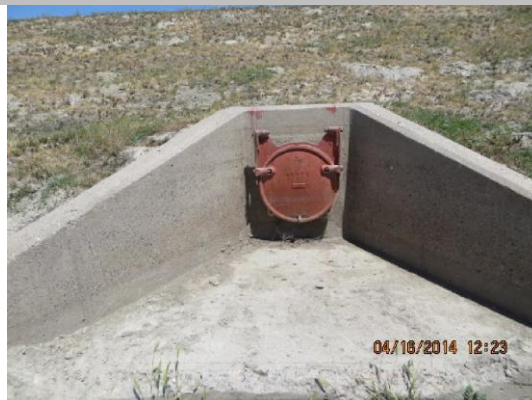
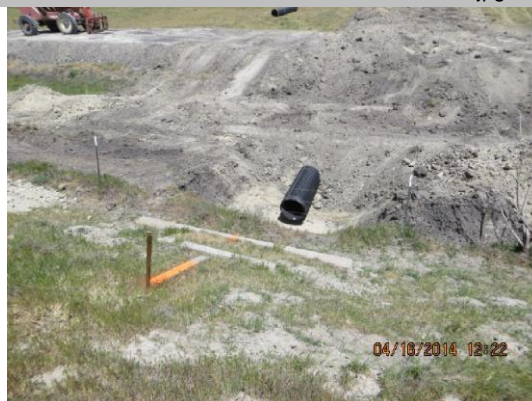
Comment Code					
Inspector Comment					
FS_ID:62436					
DS_ID:19774					
EP_NO: N/A					
Repair Type: No Action Needed					
Crossing Status: Found					
UCIP Comments:					
FIELD_STRUCT_DESC: 24-inch corrugated metal gravity drainage pipe through the levee, 9.5 feet below the crown. Flap gate on the waterside (WS) end. Concrete headwall on the landside (LS) end. Concrete U-shaped headwall on the WS end. [Additional Reference(s): DWR Levee Log, 2002 (HLM 5.58), listed as a 24-inch corrugated metal pipe (CMP). USACE San Joaquin O&M Manual, Unit 601 Part 1 (SJR601.1), 1967, Revised 25 May 2011, (HLM 5.58), listed as a 24-inch CMP]					
FS Date: 4/16/2014

Headwall, flapgate, and pipe on WS toe.

Headwall and pipe on LS toe with HDPE drain pipe being installed off LS toe.

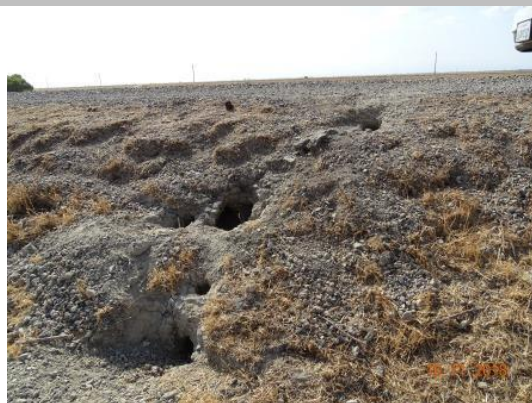
LM Start	5.94	Rating **	U	Issue No.	138
LM End	5.94	Issue Type +	Ma	Location *	LS
Category	Earthen Levee			GPS Latitude/Longitude	
				Start	End
Item	Animal Control			37.236387 °	37.236387 °
				-120.734164 °	-120.734164 °
DWR ID	DWR_NA0010_05_f_2018_138				
Comment Code					
A1 : Exterminate rodents and backfill and compact or grout burrows.					
Inspector Comment					
Several large rodent holes are located at this location.

View of large rodent holes in landside slope. (Fall 2018)

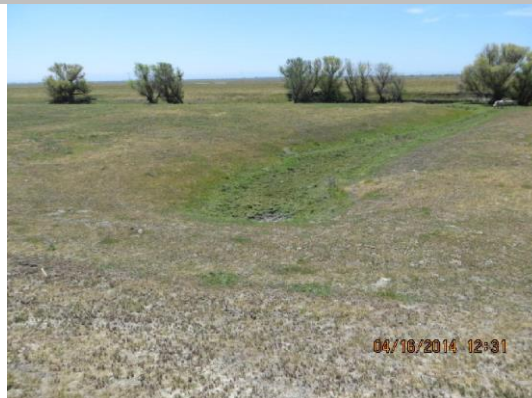
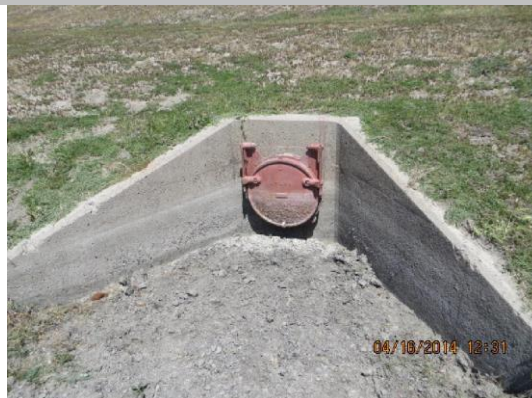
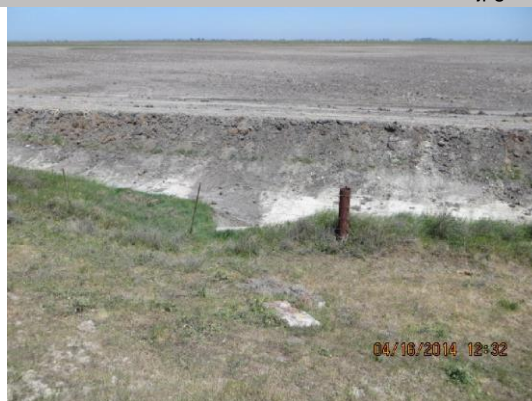
LM Start	6.35	Rating **	A/W	Issue No.	24
LM End	6.35	Issue Type +	Ma	Location *	
Category	Supplemental			GPS Latitude/Longitude	
				Start	End
Item	DWR UCIP LMA Responsibility			37.232589 °	37.232589 °
				-120.728822 °	-120.728822 °
DWR ID	19775				
Comment Code					
Inspector Comment					
FS_ID:62437 DS_ID:19775 EP_NO: N/A Repair Type: No Action Needed Crossing Status: Found UCIP Comments: FIELD_STRUCT_DESC: 24-inch corrugated metal gravity drainage pipe through the levee, 13 feet below the crown. Flap gate on the waterside (WS) end. Concrete headwall on the landside (LS) end. Concrete U-shaped headwall on the WS end. [Additional Reference(s): DWR Levee Log, 2002 (HLM 6.35), listed as a 24-inch corrugated metal pipe (CMP). USACE San Joaquin O&M Manual, Unit 601 Part 1 (SJR601.1), 1967, Revised 25 May 2011, (HLM 6.35), listed as a 24-inch CMP] FS Date: 4/16/2014

Headwall, flapgate, and pipe on WS toe.

Headwall and pipe on LS toe.

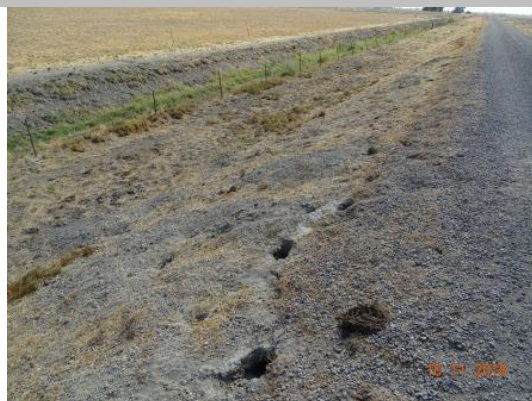
LM Start	6.40	Rating **	M	Issue No.	139
LM End	6.40	Issue Type +	Ma	Location *	LS
Category	Earthen Levee			GPS Latitude/Longitude	
				Start	End
Item	Animal Control			37.231900 °	37.231900 °
				-120.728345 °	-120.728345 °
DWR ID	DWR_NA0010_05_f_2018_139				
Comment Code					
A1 : Exterminate rodents and backfill and compact or grout burrows.					
Inspector Comment

View of rodent holes on landside shoulder. (Fall 2018)

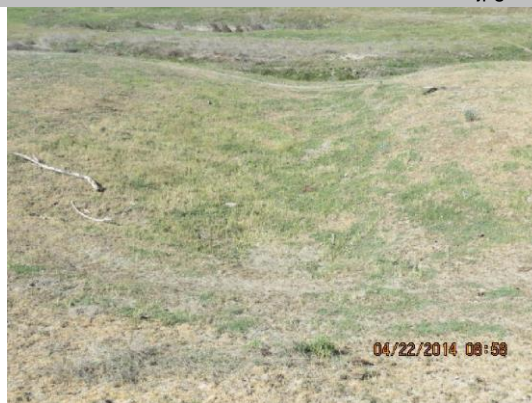
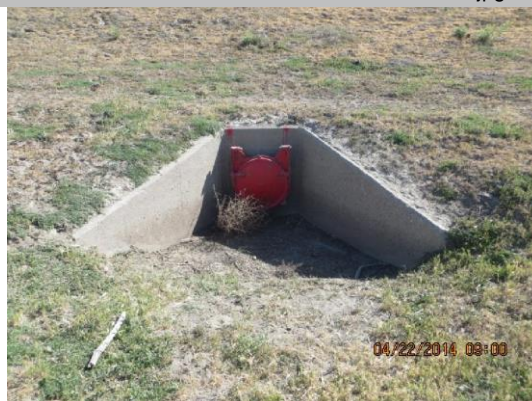
Comment Code						
Inspector Comment						
FS_ID:62428 DS_ID:19761 EP_NO: N/A Repair Type: Non-Urgent Crossing Status: Found UCIP Comments: 04/22/2014 Sediment buildup in pipe visible from landward side--recommend contacting owner to clear pipe. (W. Wylie - DWR UCIP) FIELD_STRUCT_DESC: 24-inch corrugated metal gravity drainage pipe through the levee, 12 feet below the crown. Flap gate on the waterside (WS) end. Concrete headwall on the landside (LS) end. Concrete U-shaped headwall on the waterside (WS) end. [Additional Reference(s): DWR Levee Log, 2002 (HLM 7.36), listed as a 24-inch corrugated metal pipe (CMP). USACE San Joaquin O&M Manual, Unit 601 Part 1 (SJR601.1), 1967, Revised 25 May 2011, (HLM 7.36), listed as a 24-inch CMP] FS Date: 4/22/2014

Headwall, flapgate, and pipe on WS toe.

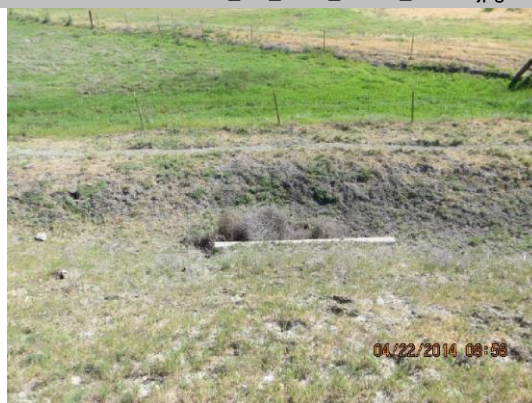
Photo 3 of 3 : UCIP\_SP\_2021\_62428\_62112.jpg

Headwall and pipe on LS toe.

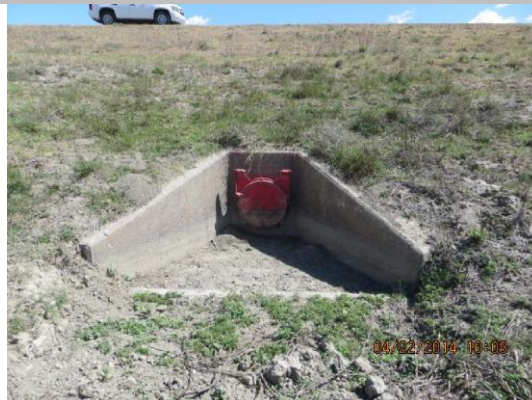
Photo 2 of 3 : UCIP\_SP\_2021\_62451\_62183.jpg

Headwall, flapgate, and pipe on WS toe

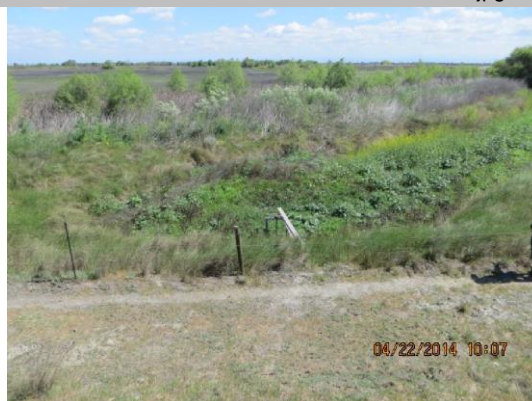
Photo 3 of 3 : UCIP\_SP\_2021\_62451\_62181.jpg

Headwall, slidegate, and pipe on LS toe.

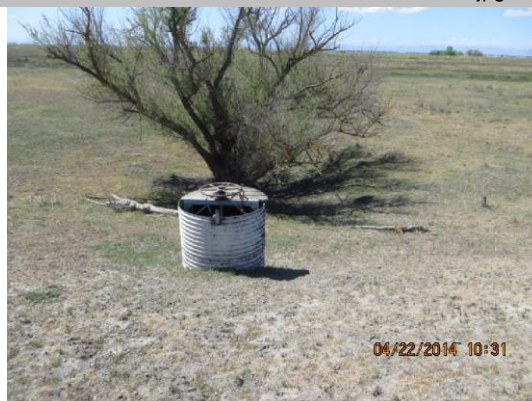
Photo 1 of 3 : UCIP\_SP\_2021\_62455\_62196.jpg

Slide gate in 48-inch CMP riser on WS slope.

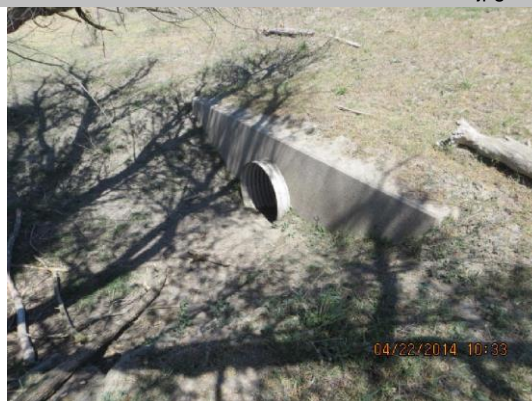
Photo 2 of 3 : UCIP\_SP\_2021\_62455\_62198.jpg

Headwall and pipe at WS toe.

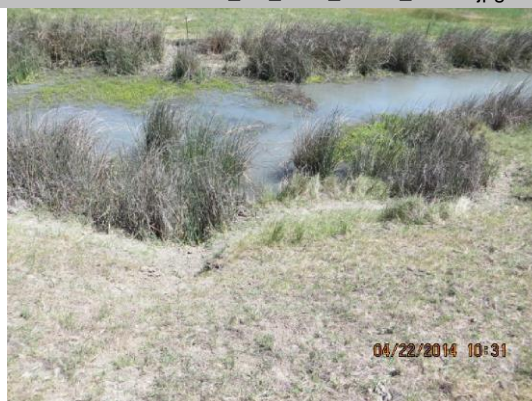
Photo 3 of 3 : UCIP\_SP\_2021\_62455\_62197.jpg

Headwall and pipe at LS toe.

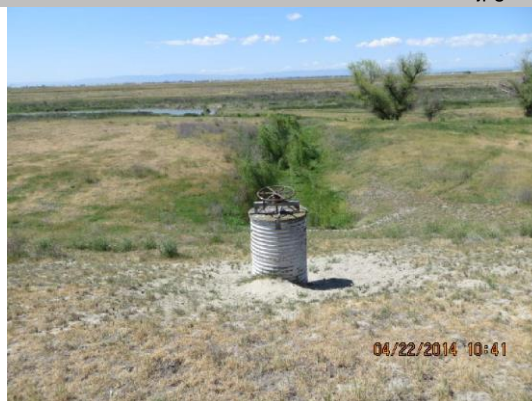
Photo 1 of 3 : UCIP\_SP\_2021\_62456\_62201.jpg

Comment Code						
Inspector Comment						
FS_ID:62456 DS_ID:19767 EP_NO: N/A Repair Type: Non-Urgent Crossing Status: Found UCIP Comments: 04/22/2014 Slidegate actuator appears bent and may not work properly (WS slope). (W. Wylie - DWR UCIP) FIELD_STRUCT_DESC: 24-inch corrugated metal gravity drainage pipe through the levee, 15 feet below the crown. Slide gate in a 36-inch corrugated metal pipe (CMP) riser on the waterside (WS) slope. Concrete headwall on each end. [Additional Reference(s): DWR Levee Log, 2002 (HLM 10.04), listed as a 24-inch corrugated metal pipe (CMP). USACE San Joaquin O&M Manual, Unit 601 Part 1 (SJR601.1), 1967, Revised 25 May 2011, (HLM 10.05), listed as a 24-inch CMP]. FS Date: 4/22/2014

Slidegate in CMP riser on WS slope.

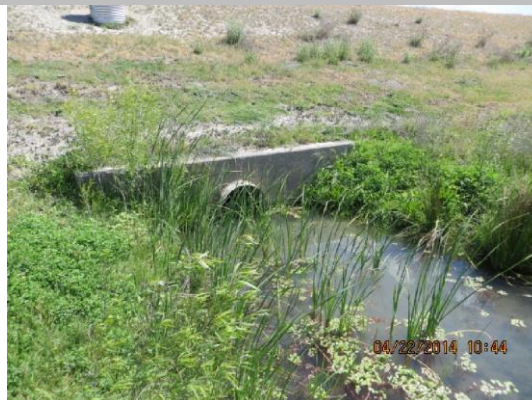
Photo 2 of 3 : UCIP\_SP\_2021\_62456\_62202.jpg

Concrete headwall and pipe on WS toe.

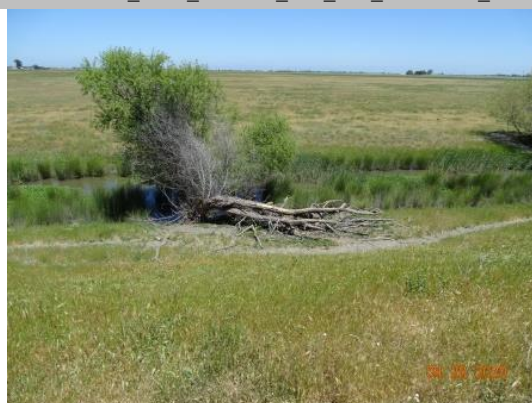
Photo 1 of 1 : SP\_2021\_NA0010\_123\_146\_20210308\_00035.jpg

LM Start	11.44	Rating **	M	Issue No.	146
LM End	11.44	Issue Type +	Ma	Location *	LS
Category	Earthen Levee			GPS Latitude/Longitude	
				Start	End
Item	Trim / Thin Trees			37.187021 °	37.187021 °
				-120.658564 °	-120.658564 °
DWR ID	DWR_NA0010_05_f_2018_146				
Comment Code					
T2 : Thin trees to allow visibility of the ground and room to flood fight.					
Inspector Comment					
Fallen tree limbs are located on the levee toe.

Tree limbs and trunk on levee toe. (Spring 2020)

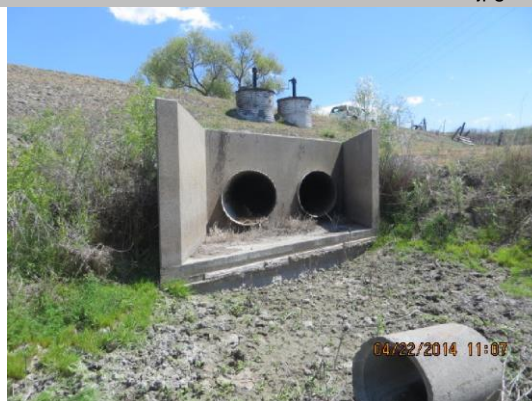
Photo 1 of 3 : UCIP\_SP\_2021\_62457\_62219.jpg

Slidegate in CMP riser, concrete headwall and pipe visible on WS slope.

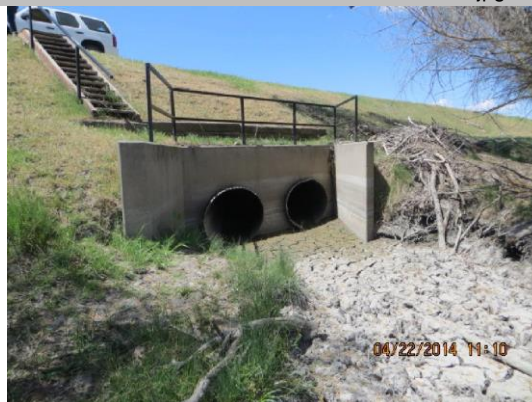
Photo 2 of 3 : UCIP\_SP\_2021\_62457\_62217.jpg

Stairs, concrete headwall, and pipe visible on LS slope.

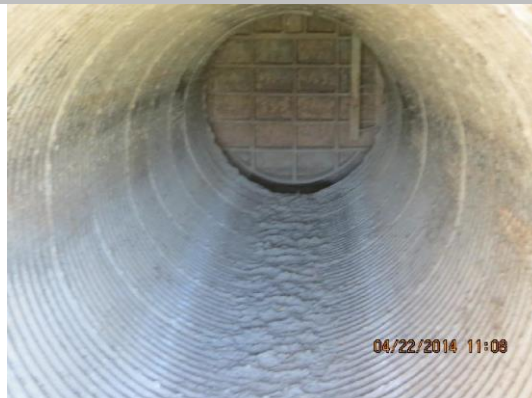
Photo 3 of 3 : UCIP\_SP\_2021\_62457\_62218.jpg

Inside pipe at LS toe.

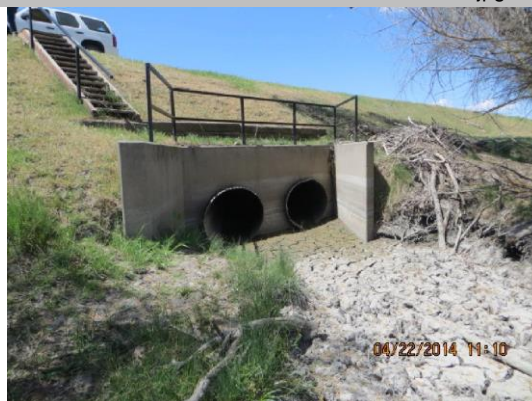
Photo 2 of 3 : UCIP\_SP\_2021\_62458\_62214.jpg

Stairs, concrete headwall and pipe on LS toe.

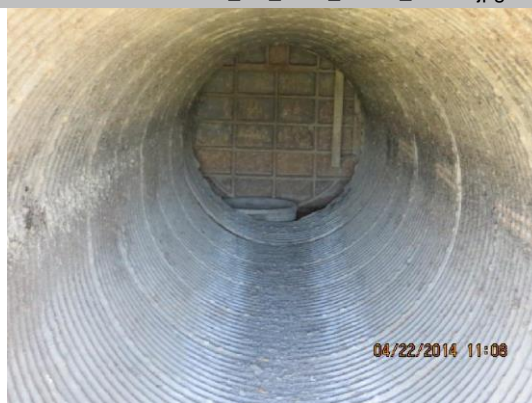
Photo 3 of 3 : UCIP\_SP\_2021\_62458\_62215.jpg

Inside pipe on WS toe.

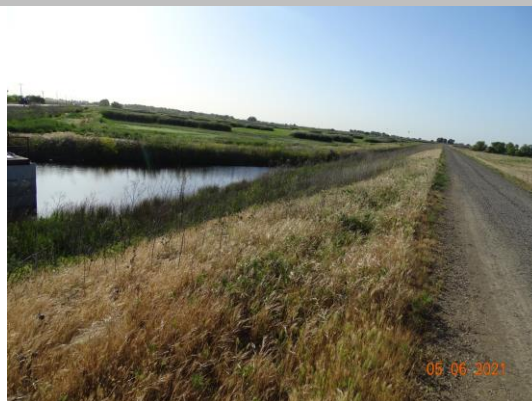
Photo 1 of 1 : SP\_2021\_NA0010\_123\_108\_20210517\_00321.jpg

LM Start	11.55	Rating **	M	Issue No.	108
LM End	13.77	Issue Type +	Ma	Location *	LS
Category	Earthen Levee			GPS Latitude/Longitude	
				Start	End
Item	Vegetation			37.185852 °	37.167627 °
				-120.657196 °	-120.629321 °
DWR ID	DWR_NA0010_05_s_2021_108				
Comment Code					
V1 : Control annual grass and weeds on the levee slopes and easements.					
Inspector Comment

View of vegetation on the landside slope. (Spring 2021)

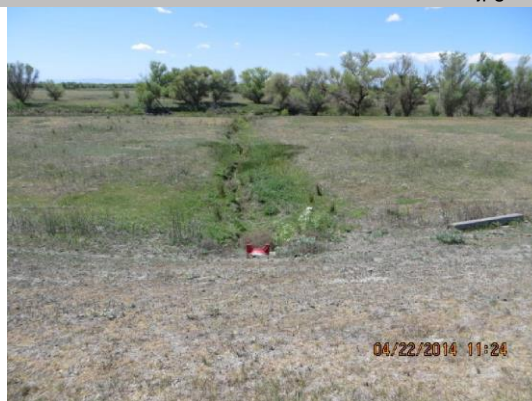
Photo 1 of 3 : UCIP\_SP\_2021\_62459\_62221.jpg

Headwall, flapgate, and pipe at WS toe.

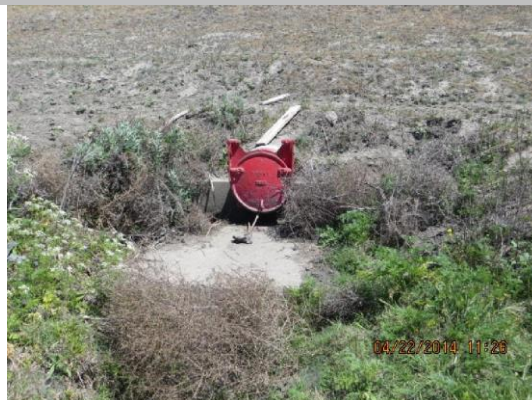
Photo 2 of 3 : UCIP\_SP\_2021\_62459\_62223.jpg

Headwall, flapgate, and pipe at WS toe.

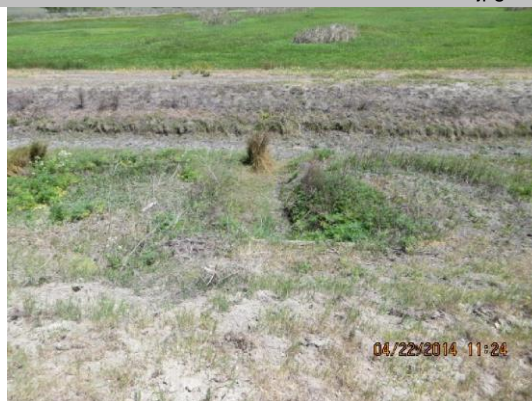
Photo 3 of 3 : UCIP\_SP\_2021\_62459\_62222.jpg

Concrete headwall and pipe at LS toe.

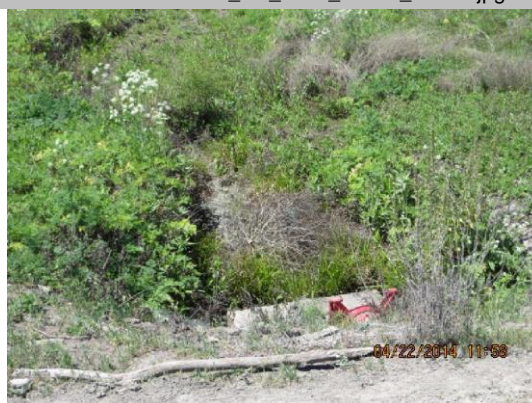
Photo 1 of 3 : UCIP\_SP\_2021\_62460\_62225.jpg

Headwall, flapgate, and pipe on WS toe.

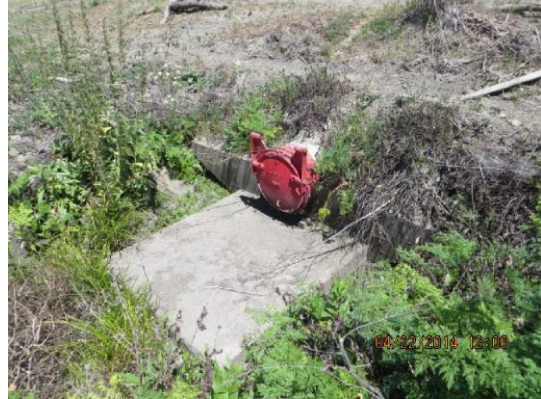
Photo 2 of 3 : UCIP\_SP\_2021\_62460\_62227.jpg

Headwall, flapgate, and pipe on WS toe.

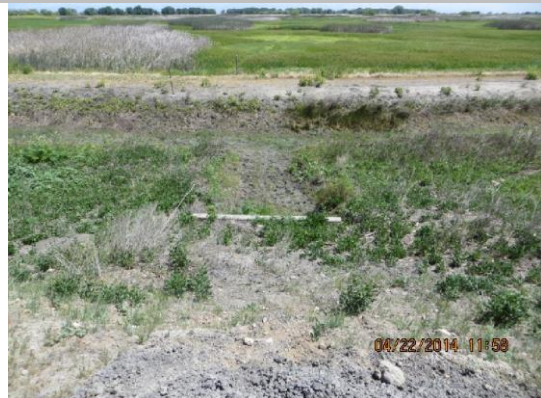
Photo 3 of 3 : UCIP\_SP\_2021\_62460\_62226.jpg

Headwall and pipe on LS toe.

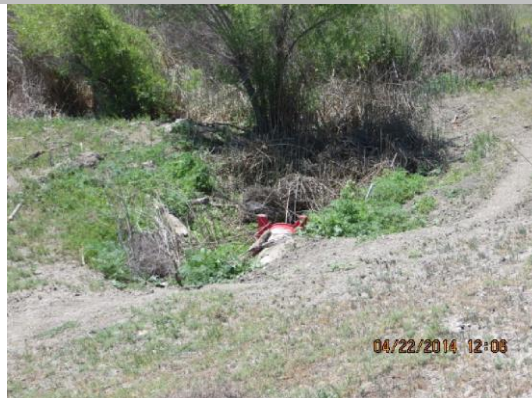
Photo 1 of 3 : UCIP\_SP\_2021\_62461\_62230.jpg

Headwall, flapgate, and pipe on WS toe.

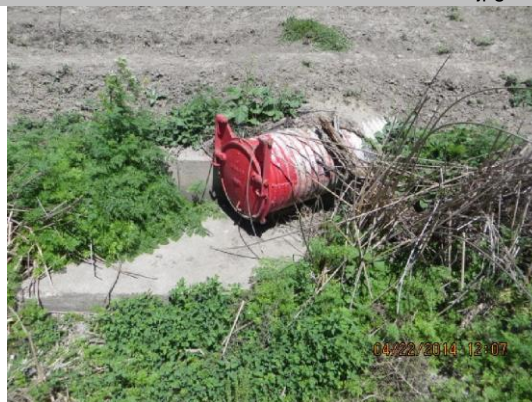
Photo 2 of 3 : UCIP\_SP\_2021\_62461\_62229.jpg

Headwall, flapgate, and pipe on WS toe.

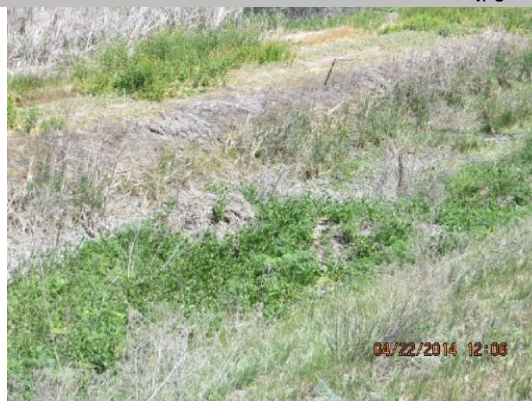
Photo 3 of 3 : UCIP\_SP\_2021\_62461\_62231.jpg

Headwall and pipe on LS toe.

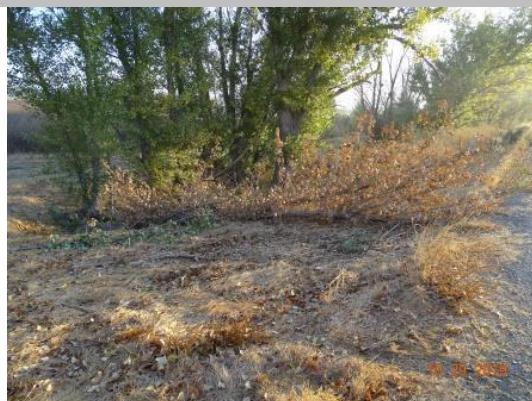
Photo 1 of 1 : SP\_2021\_NA0010\_123\_158\_20210308\_00042.jpg

LM Start	12.88	Rating **	M	Issue No.	158
LM End	12.88	Issue Type +	Ma	Location *	LS
Category	Earthen Levee			GPS Latitude/Longitude	
				Start	End
Item	Encroachments			37.175807 °	37.175807 °
				-120.641139 °	-120.641139 °
DWR ID	DWR_NA0010_05_f_2019_158				
Comment Code					
TR : Tree or limb					
Inspector Comment					
Tree limb on the landside slope should be removed.

View of downed tree limb on the landside slope. (Fall 2019)

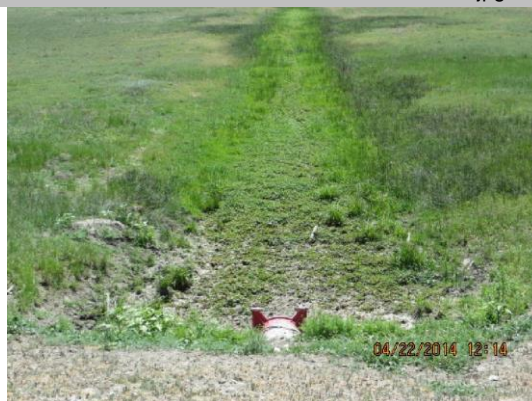
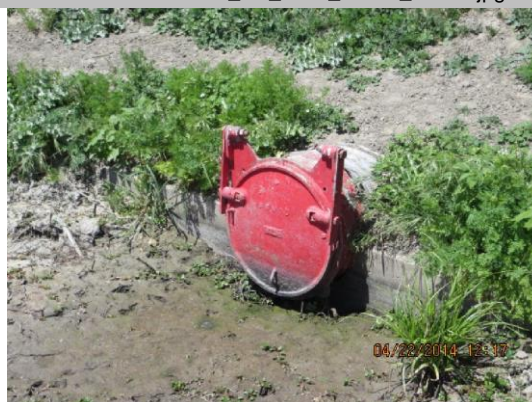
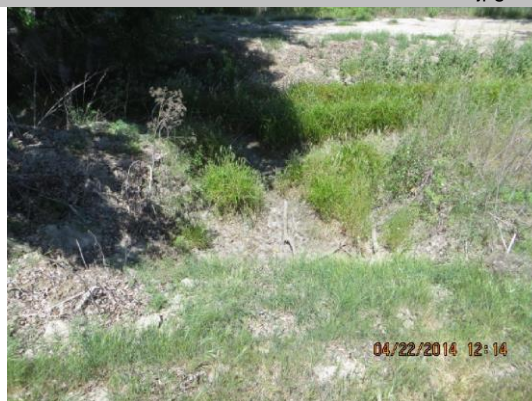
FS\_ID:62462  
DS\_ID:19707  
EP\_NO: N/A  
Repair Type: Non-Urgent  
Crossing Status: Found  
UCIP Comments: 04/22/2014 Sediment buildup in pipe visible from landward side--recommend contacting owner to clear pipe. (W. Wylie - DWR UCIP)  
FIELD\_STRUCT\_DESC: 24-inch corrugated metal gravity drainage pipe through the levee, 10.2 feet below the crown. Concrete headwall on the landside (LS) end with flashboards. Concrete saddle and apron on the waterside (WS) end with a flap gate. Metal screen at LS toe inlet. [Additional Reference(s): DWR Levee Log, 2002 (HLM 12.87), listed as a 24-inch corrugated metal pipe (CMP). USACE San Joaquin O&M Manual, Unit 601 Part 1 (SJR601.1), 1967, Revised 25 May 2011, (HLM 12.87), listed as a 24-inch CMP]  
FS Date: 4/22/2014

Headwall, flapgate, and pipe on WS toe.

Headwall and pipe on LS toe.

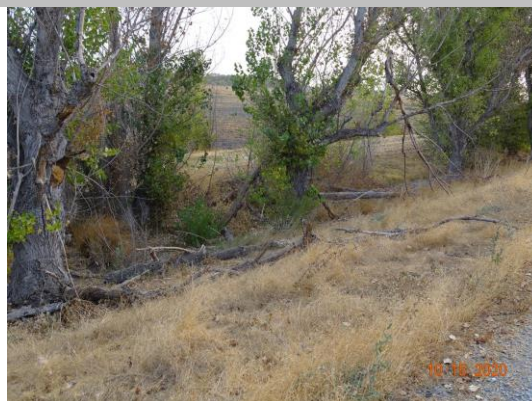
Photo 1 of 1 : SP\_2021\_NA0010\_123\_2\_20210308\_00004.jpg

LM Start	13.01	Rating **	M	Issue No.	2
LM End	13.01	Issue Type +	Ma	Location *	LS
Category	Earthen Levee			GPS Latitude/Longitude	
				Start	End
Item	Encroachments			37.175576 °	37.175576 °
				-120.638755 °	-120.638755 °
DWR ID	DWR_NA0010_05_s_2016_2				
Comment Code					
TR : Tree or limb					
Inspector Comment					
There are several downed trees on landside toe.

Looking west at down tree at landward toe. (Fall 2020)

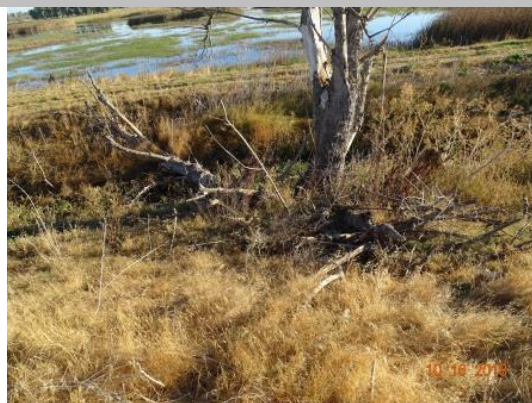
Photo 1 of 1 : SP\_2021\_NA0010\_123\_150\_20210308\_00038.jpg

LM Start	13.05	Rating **	M	Issue No.	150
LM End	13.05	Issue Type +	Ma	Location *	LS
Category	Earthen Levee			GPS Latitude/Longitude	
				Start	End
Item	Encroachments			37.175314 °	37.175314 °
				-120.638034 °	-120.638034 °
DWR ID	DWR_NA0010_05_f_2018_150				
Comment Code					
TR : Tree or limb					
Inspector Comment					
There are tree trimmings on the levee slope and toe.

Tree trimmings on landside slope and toe. (Fall 2018)

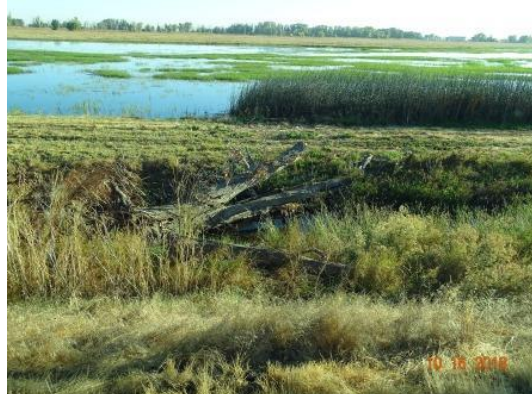
Photo 1 of 1 : SP\_2021\_NA0010\_123\_152\_20210308\_00039.jpg

LM Start	13.15	Rating **	M	Issue No.	152
LM End	13.15	Issue Type +	Ma	Location *	LS
Category	Earthen Levee			GPS Latitude/Longitude	
				Start	End
Item	Encroachments			37.174444 °	37.174444 °
				-120.636589 °	-120.636589 °
DWR ID	DWR_NA0010_05_f_2018_152				
Comment Code					
TR : Tree or limb					
Inspector Comment					
There is a tree trunk on landside toe.

Tree trunk on landside toe. (Fall 2018)

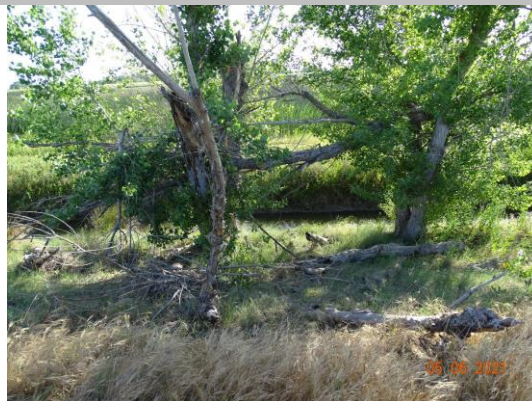
Photo 1 of 1 : SP\_2021\_NA0010\_123\_112\_20210517\_00323.jpg

LM Start	13.37	Rating **	U	Issue No.	112
LM End	13.37	Issue Type +	Ma	Location *	LS
Category	Earthen Levee			GPS Latitude/Longitude	
				Start	End
Item	Encroachments			37.172033 °	37.172033 °
				-120.634005 °	-120.634005 °
DWR ID	DWR_NA0010_05_s_2021_112				
Comment Code					
TR : Tree or limb					
Inspector Comment

View of tree limbs on the landside toe and slope. (Spring 2021)

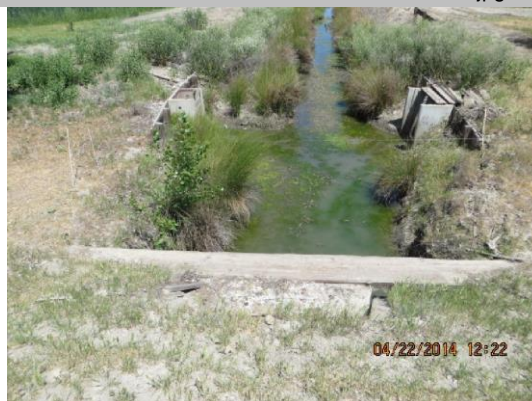
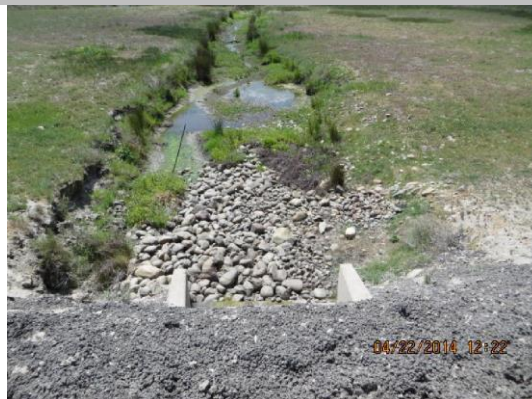
FS\_ID:62463  
DS\_ID:19708  
EP\_NO: N/A  
Repair Type: Non-Urgent  
Crossing Status: Found  
UCIP Comments: 04/22/2014 Some erosion around headwall on the WS toe and there are animal burrows on both slopes. (W. Wylie - DWR UCIP)  
FIELD\_STRUCT\_DESC: 48-inch corrugated metal gravity drainage pipe through the levee, 10 feet below the crown. Flap gate on the waterside (WS) end. Flashboard attachment in concrete U-shaped headwall on the landside (LS) end. Concrete U-shaped headwall on the WS end. [Additional Reference(s): DWR Levee Log, 2002 (HLM 13.40), listed as a 48-inch corrugated metal pipe (CMP). USACE San Joaquin O&M Manual, Unit 601 Part 1 (SJR601.1), 1967, Revised 25 May 2011, (HLM 13.40), listed as a 48-inch CMP].  
FS Date: 4/22/2014

Headwall and pipe on LS toe.

Headwall, flapgate, and pipe on WS toe.

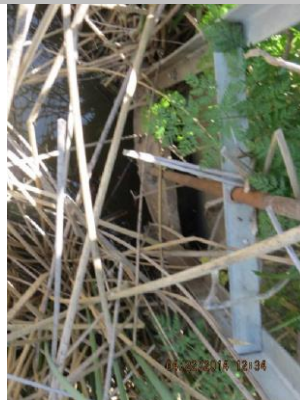
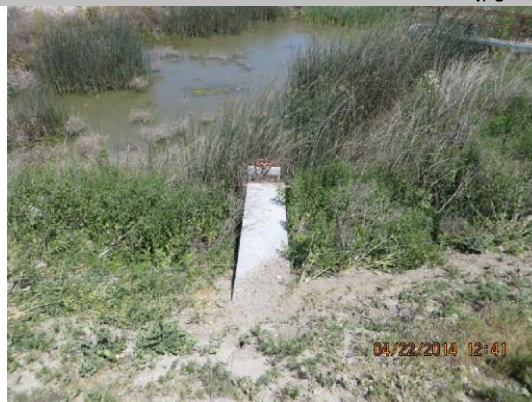
Comment Code					
Inspector Comment					
FS_ID:62520					
DS_ID:19709					
EP_NO: N/A					
Repair Type: Non-Urgent					
Crossing Status: Found					
UCIP Comments: 04/22/2014 Pipe not visible and may need to have silt removed from outlet on WS toe. (W. Wylie - DWR UCIP)					
FIELD_STRUCT_DESC: 24-inch corrugated metal gravity drainage pipe through the levee, 10 feet below the crown. Flap gate on the waterside (WS) end. Slide gate on concrete headwall at the landside (LS) toe. Concrete saddle and apron on the WS end. [Additional Reference(s): DWR Levee Log, 2002 (HLM 13.70), listed as a 24-inch corrugated metal pipe (CMP). USACE San Joaquin O&M Manual, Unit 601 Part 1 (SJR601.1), 1967, Revised 25 May 2011, (recorded as HLM 14.72 should be 13.72), listed as a 24-inch CMP]					
FS Date: 4/22/2014

Slide gate at concrete headwall on LS toe.

Walkway to gatevalve on LS shoulder.

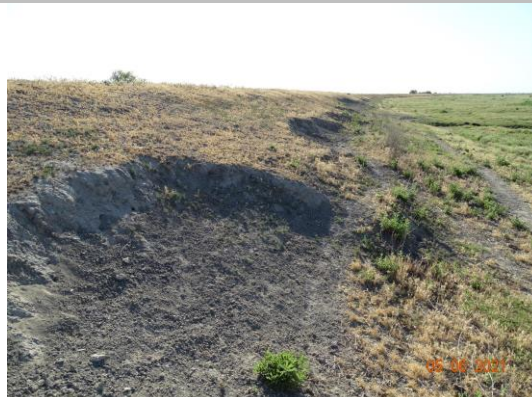
Photo 1 of 1 : SP\_2021\_NA0010\_123\_119\_20210517\_00325.jpg

LM Start	14.42	Rating **	M	Issue No.	119
LM End	14.49	Issue Type +	Ma	Location *	WS
Category	Earthen Levee			GPS Latitude/Longitude	
				Start	End
Item	Erosion / Bank Caving			37.162949 °	37.162540 °
				-120.619138 °	-120.618091 °
DWR ID	DWR_NA0010_05_s_2021_119				
Comment Code					
E1 : Note and monitor erosion site.					
Inspector Comment					
Slope erosion on the waterside slope. Possibly caused by livestock.

Looking upstream along the waterside slope at erosion spots. (Spring 2021)

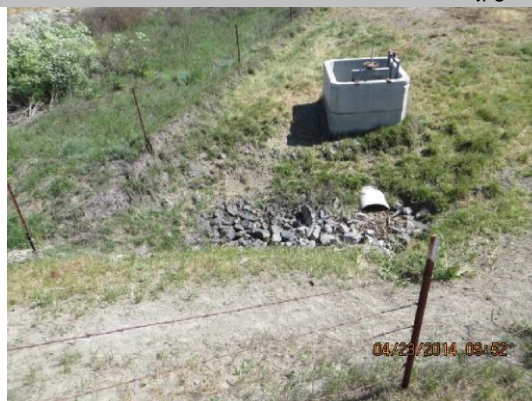
Photo 1 of 3 : UCIP\_SP\_2021\_62440\_62454.jpg

FS\_ID:62440  
DS\_ID:19712  
EP\_NO: N/A  
Repair Type: Non-Urgent  
Crossing Status: Found  
UCIP Comments: 04/23/2014 Minor erosion at headwall on WS toe.  
(W. Wylie - DWR UCIP)  
FIELD\_STRUCT\_DESC: 36-inch corrugated metal gravity drainage pipe through the levee, 11.9 feet below the crown. Flap gate on the waterside (WS) end. Concrete headwall on each end. [Additional Reference(s): DWR Levee Log, 2002 (HLM 15.08), listed as a 36-inch corrugated metal pipe (CMP). USACE San Joaquin O&M Manual, Unit 601 Part 1 (SJR601.1), 1967, Revised 25 May 2011, (HLM 15.09), listed as a 36-inch CMP]  
FS Date: 4/23/2014

Headwall and inlet on LS toe.

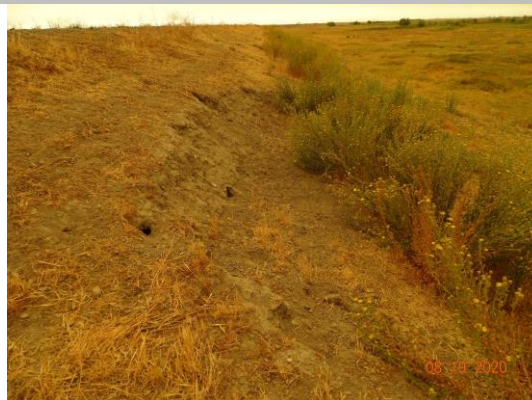
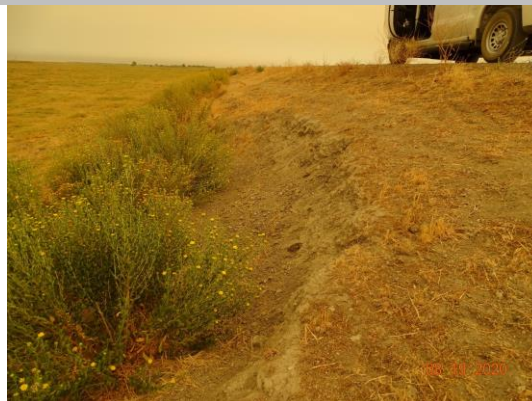
LM Start	15.31	Rating **	M	Issue No.	3
LM End	15.32	Issue Type +	Ma	Location *	WS
Category	Supplemental			GPS Latitude/Longitude	
				Start	End
Item	DWR Erosion Survey			37.154837 °	37.154837 °
				-120.606737 °	-120.606737 °
DWR ID	NA0010U05RM13.09				
Comment Code					
Inspector Comment					
Site ID: NA0010U05RM13.09 08/19/2020: This site was discovered during the DWR Spring 2020 Levee Inspections. There is a 20-ft long and an 8-ft long erosion pocket, with scarp heights of up to 3 ft. The erosion has cut into the levee prism. There are signs of rodent and cattle activity.

8/19/2020: View of the erosion pocket looking upstream. The erosion has cut into the levee prism.

8/19/2020: Another view of the erosion pocket, looking downstream.

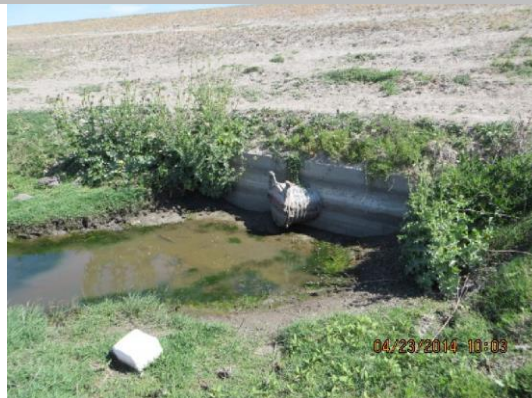
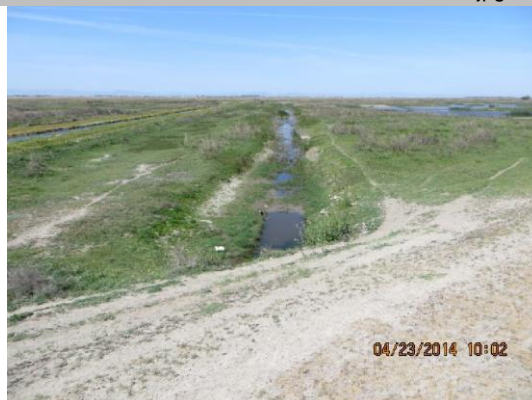
Comment Code					
Inspector Comment					
FS_ID:62441 DS_ID:19713 EP_NO: N/A Repair Type: Non-Urgent Crossing Status: Found UCIP Comments: 04/23/2014 Sediment buildup in pipe visible from landward side--recommend contacting owner to clear pipe. (W. Wylie - DWR UCIP) FIELD_STRUCT_DESC: 24-inch corrugated metal gravity drainage pipe through the levee, 11 feet below the crown. Flap gate on the waterside (WS) end. Concrete headwall on each end. [Additional Reference(s): DWR Levee Log, 2002 (HLM 15.74), listed as a 24-inch corrugated metal pipe (CMP). USACE San Joaquin O&M Manual, Unit 601 Part 1 (SJR601.1), 1967, Revised 25 May 2011, (HLM 15.74), listed as a 24-inch CMP] FS Date: 4/23/2014

Headwall, pipe, and flapgate on WS toe.

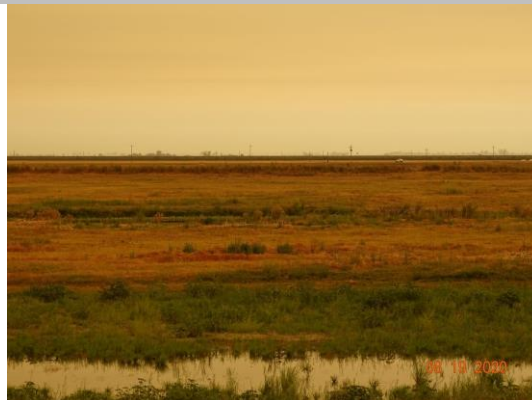
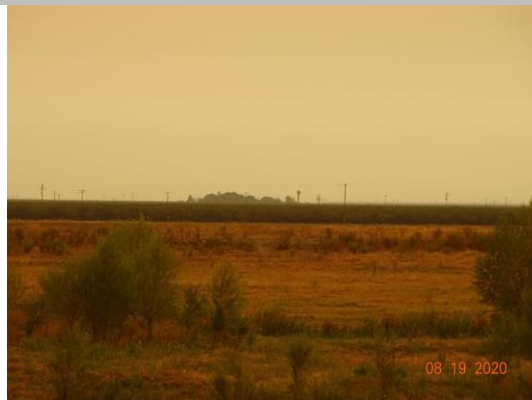
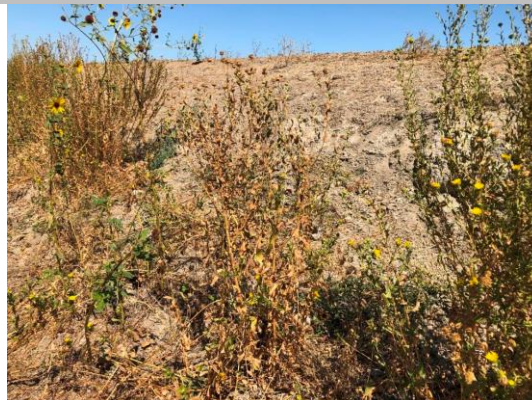
LM Start	<b>16.09</b>	Rating **	M	Issue No.	<b>1 (cont)</b>
LM End	<b>16.13</b>	Issue Type +	Ma	Location *

08/19/2020: Due to ongoing construction both up and downstream, this site could not be accessed and only be viewed from the opposite bank across the bypass. Unable to determine if the conditions changed since the previous inspection.

09/10/2019: The erosion has become worse during the past 2 flood seasons. The erosion length has increased to approximately 200 ft from 55 ft. Signs of animal activity were observed.

8/19/2020: View of the erosion from across the bypass.

8/19/2020: Another view of the erosion from across the bypass.

9/10/2019: Looking at the erosion from the levee toe. Note the dense vegetation.

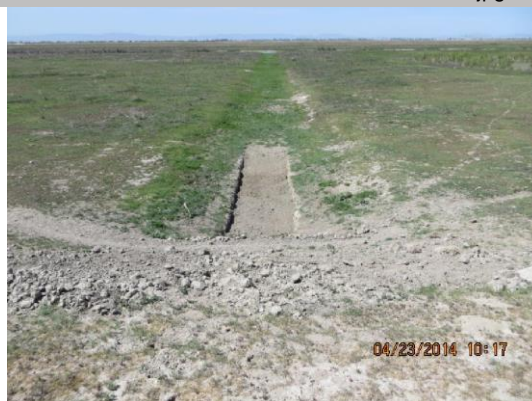
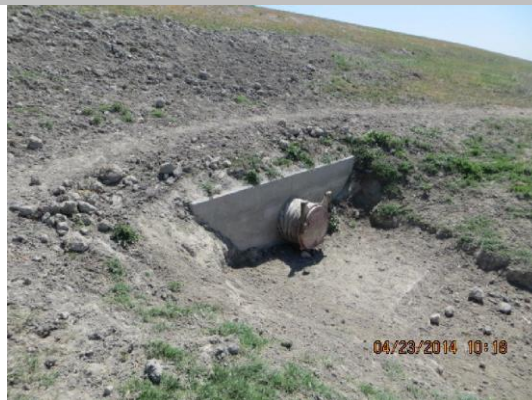
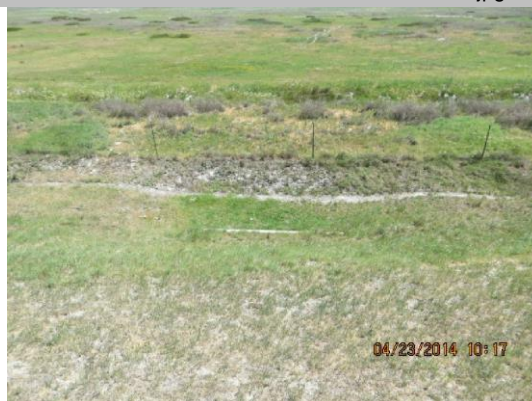
LM Start	<b>16.68</b>	Rating **	M	Issue No.	<b>44 (cont)</b>
LM End	<b>16.68</b>	Issue Type +	Ma	Location *

LM Start	16.68	Rating **	M	Issue No.	44
LM End	16.68	Issue Type +	Ma	Location *	
Category	Supplemental			GPS Latitude/Longitude	
				Start	End
Item	DWR UCIP LMA Responsibility			37.138760 °	37.138760 °
				-120.592393 °	-120.592393 °
DWR ID	19716				
Comment Code					
Inspector Comment					
FS_ID:62444 DS_ID:19716 EP_NO: N/A Repair Type: Non-Urgent Crossing Status: Found UCIP Comments: 04/23/2014 Pipe heavily silted on LS toe. (W. Wylie - DWR UCIP) FIELD_STRUCT_DESC: 24-inch corrugated metal gravity drainage pipe through the levee, 10.5 feet below the crown. Flap gate on the waterside (WS) end. Concrete headwall on each end. [Additional Reference(s): DWR Levee Log, 2002 (HLM 16.66), listed as a 24-inch corrugated metal pipe (CMP). USACE San Joaquin O&M Manual, Unit 601 Part 1 (SJR601.1), 1967, Revised 25 May 2011, (HLM 16.67), listed as a 24-inch CMP] FS Date: 4/23/2014

Headwall, flapgate, and pipe visible on WS toe.

Concrete headwall and pipe visible on LS toe.

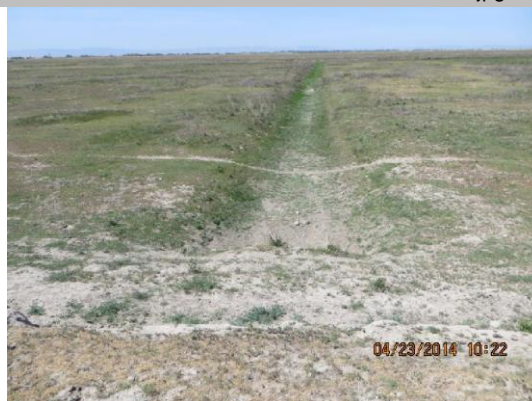
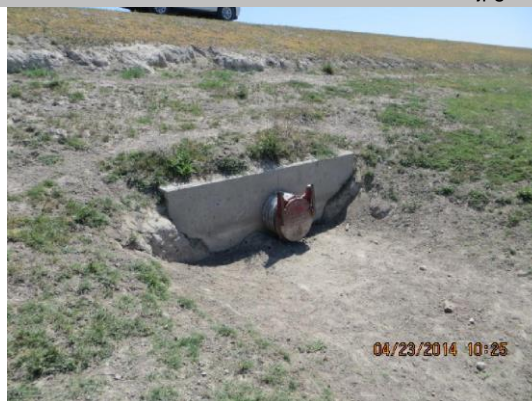
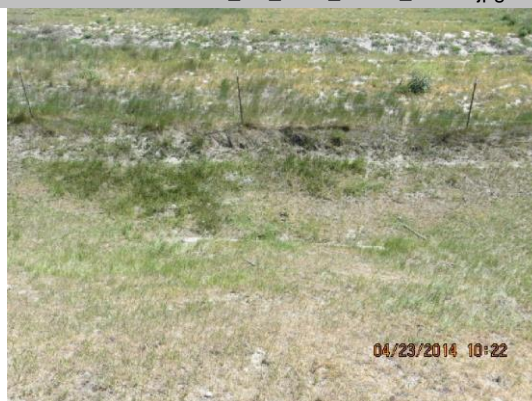
LM Start	<b>17.22</b>	Rating **	M	Issue No.	<b>45</b>
LM End	<b>17.22</b>	Issue Type +	Ma	Location *	
Category	Supplemental		GPS Latitude/Longitude		
			Start	End	
Item	DWR UCIP LMA Responsibility		37.132211 °	37.132211 °	
			-120.587106 °	-120.587106 °	
DWR ID	19717

FS\_ID:62445  
 DS\_ID:19717  
 EP\_NO: N/A  
 Repair Type: Non-Urgent  
 Crossing Status: Found  
 UCIP Comments: 04/23/2014 Sediment buildup in pipe visible from landward side--recommend contacting owner to clear pipe. (W. Wylie - DWR UCIP)  
 FIELD\_STRUCT\_DESC: 24-inch corrugated metal gravity drainage pipe through the levee, 12 feet below the crown. Flap gate on the waterside (WS) end. Concrete headwall on each end. [Additional Reference(s): DWR Levee Log, 2002 (HLM 17.21), listed as a 24-inch corrugated metal pipe (CMP). USACE San Joaquin O&M Manual, Unit 601 Part 1 (SJR601.1), 1967, Revised 25 May 2011, (HLM 17.20), listed as a 24-inch CMP]  
 FS Date: 4/23/2014

Headwall, flapgate, and pipe visible on WS toe.

Headwall and pipe visible on LS toe.
