**Flood Control Project Maintenance  
Levee Inspections**

## Maintenance Issue Types Only, Levee Inspection Report By Mile - Spring 2021

### Lower San Joaquin Levee District

Waterway	Bank	Unit Miles	Inspection Start/End	Inspector
Unit No. 01 San Joaquin River	Right	22.52	05/04/2021 05/04/2021	Corey Fujitani

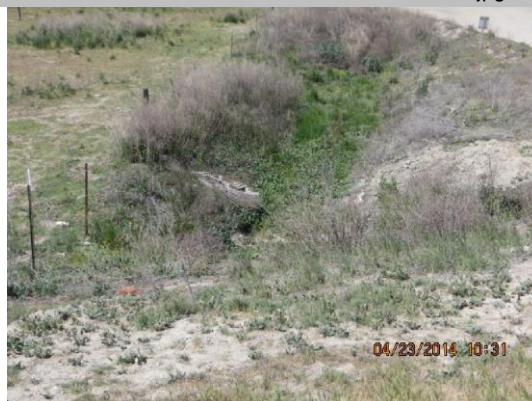
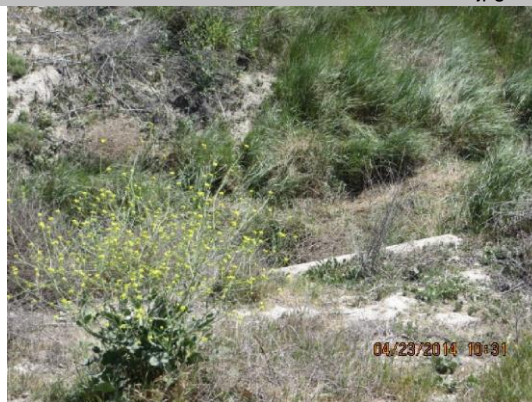
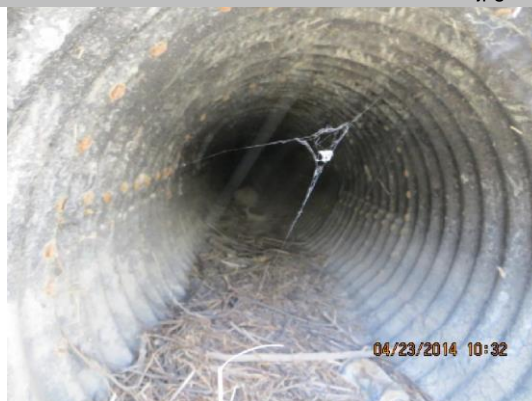
LM Start	17.54	Rating **	M	Issue No.	46 (cont)
LM End	17.54	Issue Type +	Ma	Location *

Comment Code					
Inspector Comment					
FS_ID:62446 DS_ID:19743 EP_NO: N/A Repair Type: Non-Urgent Crossing Status: Found UCIP Comments: 04/23/2014 Sediment buildup in pipe visible from landward side--recommend contacting owner to clear pipe. (W. Wylie - DWR UCIP) FIELD_STRUCT_DESC: 24-inch corrugated metal gravity drainage pipe through the levee, 9.8 feet below the crown. Flap gate on the waterside (WS) end. Concrete headwall on each end. [Additional Reference(s): DWR Levee Log, 2002 (HLM 17.52), listed as a 24-inch corrugated metal pipe (CMP). USACE San Joaquin O&M Manual, Unit 601 Part 1 (SJR601.1), 1967, Revised 25 May 2011, (HLM 17.52), listed as a 24-inch CMP] FS Date: 4/23/2014

Headwall, pipe, and flapgate visible on WS toe.

Pipe and headwall visible on LS toe.

Inside pipe on LS toe.

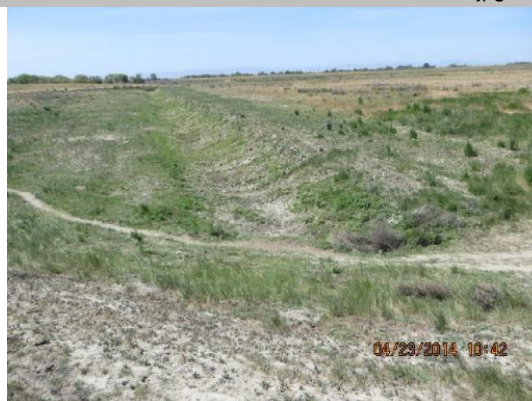
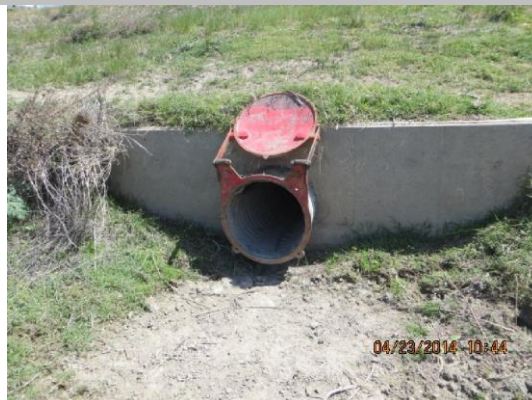
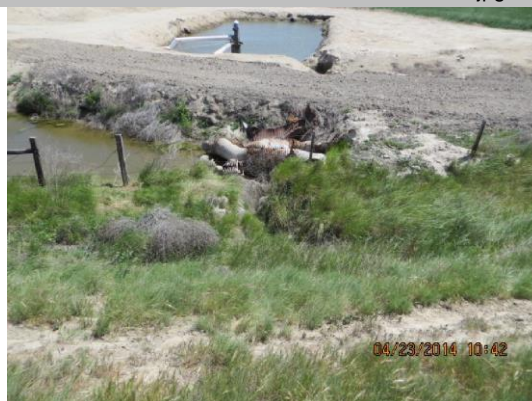
LM Start	<b>18.09</b>	Rating **	M	Issue No.	<b>47 (cont)</b>
LM End	<b>18.09</b>	Issue Type +	Ma	Location *

LM Start	18.09	Rating **	M	Issue No.	47
LM End	18.09	Issue Type +	Ma	Location *	
Category	Supplemental			GPS Latitude/Longitude	
				Start	End
Item	DWR UCIP LMA Responsibility			37.120309 °	37.120309 °
				-120.582041 °	-120.582041 °
DWR ID	19745				
Comment Code					
Inspector Comment					
FS_ID:62465 DS_ID:19745 EP_NO: N/A Repair Type: Non-Urgent Crossing Status: Found UCIP Comments: 04/23/2014 Animal burrows in levee on both slopes. (W. Wylie - DWR UCIP) FIELD_STRUCT_DESC: 24-inch corrugated metal gravity drainage pipe through the levee, 12.4 feet below the crown. Flap gate on the waterside (WS) end. Concrete headwall on each end. [Additional Reference(s): DWR Levee Log, 2002 (HLM 18.07), listed as a 24-inch corrugated metal pipe (CMP). USACE San Joaquin O&M Manual, Unit 601 Part 1 (SJR601.1), 1967, Revised 25 May 2011, (HLM 18.07), listed as a 24-inch CMP] FS Date: 4/23/2014

Headwall, pipe, and flapgate on WS toe.

Headwall and pipe visible on LS toe.

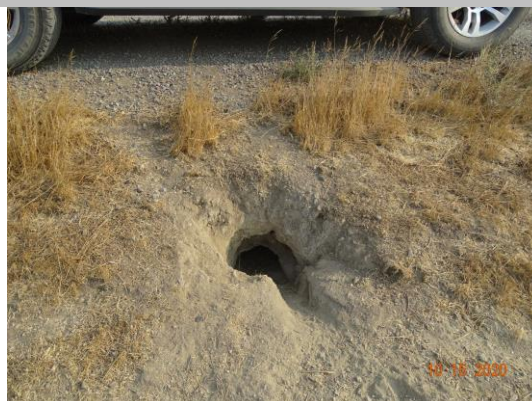
LM Start	18.50	Rating **	U	Issue No.	114
LM End	18.50	Issue Type +	Ma	Location *	WS
Category	Earthen Levee			GPS Latitude/Longitude	
				Start	End
Item	Animal Control			37.115960 °	37.115960 °
				-120.577170 °	-120.577170 °
DWR ID	DWR_NA0010_05_f_2020_114				
Comment Code					
A3 : No rodents visible, but rodent burrows visible; need to backfill and compact or grout burrows.					
Inspector Comment					
Burrow appears to connect to hole in landside shoulder.

View of rodent burrow in the waterside shoulder. (Fall 2020)

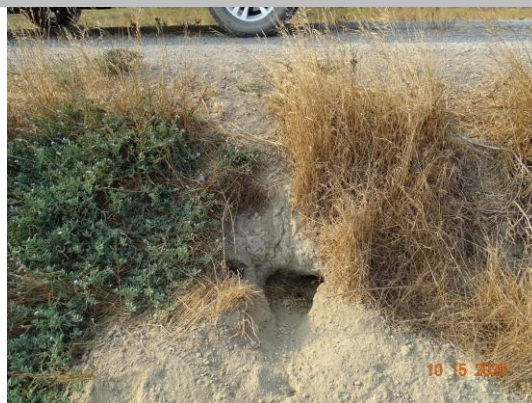
LM Start	18.50	Rating **	U	Issue No.	118
LM End	18.50	Issue Type +	Ma	Location *	LS
Category	Earthen Levee			GPS Latitude/Longitude	
				Start	End
Item	Animal Control			37.115960 °	37.115960 °
				-120.577170 °	-120.577170 °
DWR ID	DWR_NA0010_05_f_2020_118				
Comment Code					
A3 : No rodents visible, but rodent burrows visible; need to backfill and compact or grout burrows.					
Inspector Comment					
Burrow appears to connect to hole in waterside shoulder.

Large rodent hole in the landside shoulder. (Fall 2020)

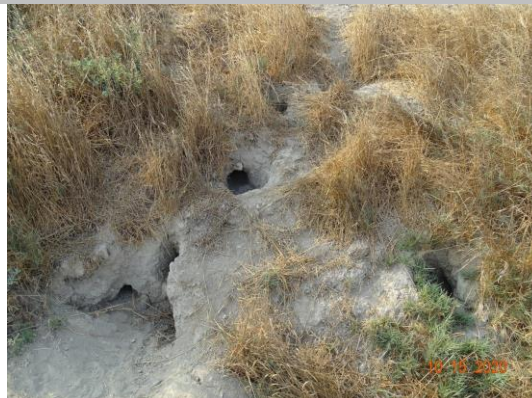
LM Start	18.62	Rating **	U	Issue No.	126
LM End	18.62	Issue Type +	Ma	Location *	LS
Category	Earthen Levee			GPS Latitude/Longitude	
				Start	End
Item	Animal Control			37.115481 °	37.115481 °
				-120.575126 °	-120.575126 °
DWR ID	DWR_NA0010_05_f_2020_126				
Comment Code					
A3 : No rodents visible, but rodent burrows visible; need to backfill and compact or grout burrows.					
Inspector Comment

Several large rodent holes observed at this location. (Fall 2020)

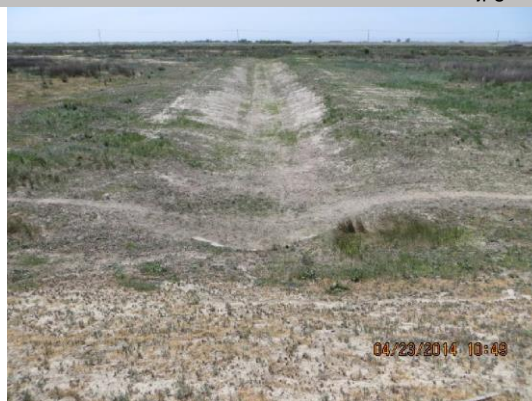
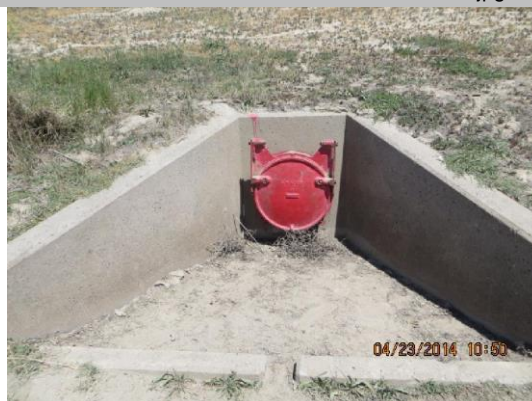
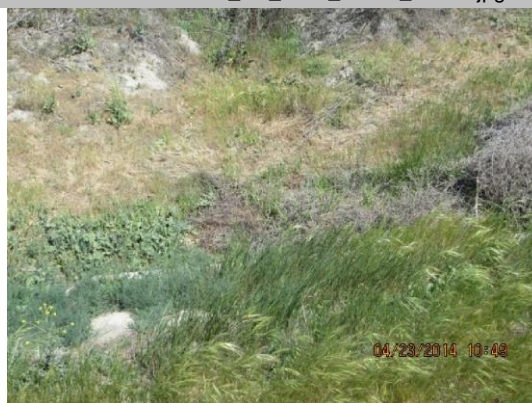
LM Start	<b>18.70</b>	Rating **	M	Issue No.	<b>48 (cont)</b>
LM End	<b>18.70</b>	Issue Type +	Ma	Location *	
Category	Supplemental		GPS Latitude/Longitude		
			Start	End	
Item	DWR UCIP LMA Responsibility		37.115472 °	37.115472 °	
			-120.573628 °	-120.573628 °	
DWR ID	19746

Comment Code						
Inspector Comment						
FS_ID:62466 DS_ID:19746 EP_NO: N/A Repair Type: Non-Urgent Crossing Status: Found UCIP Comments: 04/23/2014 Dense vegetation limits the inspector's visibility to identify signs of pipe failure (leaks) along the landward slope. Recommend removing vegetation along pipe alignment to conduct proper inspection of structure. (W. Wylie - DWR UCIP) FIELD_STRUCT_DESC: 24-inch corrugated metal gravity drainage pipe through the levee, 10 feet below the crown. Flap gate on the waterside (WS) end. Concrete headwall on the landside (LS) end. Concrete U-shaped headwall on the WS end. [Additional Reference(s): DWR Levee Log, 2002 (HLM 18.68), listed as a 24-inch corrugated metal pipe (CMP). USACE San Joaquin O&M Manual, Unit 601 Part 1 (SJR601.1), 1967, Revised 25 May 2011, (HLM 18.68), listed as a 24-inch CMP] FS Date: 4/23/2014

Headwall, pipe and flapgate visible on WS toe.

Headwall and pipe on LS toe.

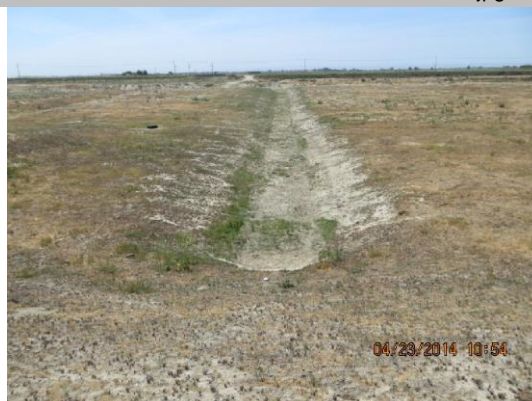
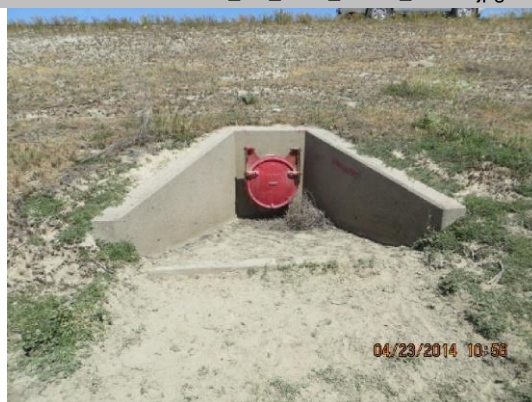
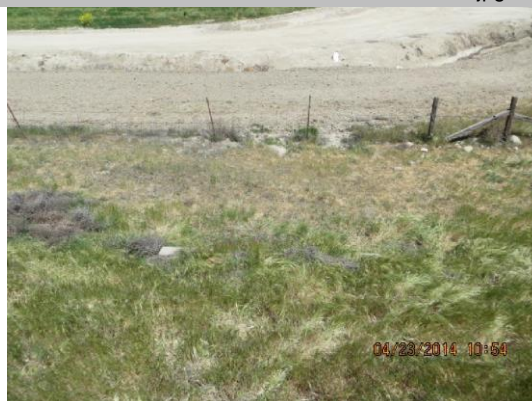
LM Start	19.15	Rating **	M	Issue No.	49 (cont)
LM End	19.15	Issue Type +	Ma	Location *

Comment Code					
Inspector Comment					
FS_ID:62467 DS_ID:19747 EP_NO: N/A Repair Type: Non-Urgent Crossing Status: Found UCIP Comments: 04/23/2014 Sediment buildup in pipe visible from landward side--recommend contacting owner to clear pipe. (W. Wylie - DWR UCIP) FIELD_STRUCT_DESC: 24-inch corrugated metal gravity drainage pipe through the levee, 10 feet below the crown. Flap gate on the waterside (WS) end. Concrete headwall on the landside (LS) end. Concrete U-shaped headwall on the WS end. [Additional Reference(s): DWR Levee Log, 2002 (HLM 19.13), listed as a 24-inch corrugated metal pipe (CMP). USACE San Joaquin O&M Manual, Unit 601 Part 1 (SJR601.1), 1967, Revised 25 May 2011, (HLM 19.11), listed as a 24-inch CMP] FS Date: 4/23/2014

Headwall, pipe, and flapgate visible on WS toe.

Headwall and pipe visible on LS toe.

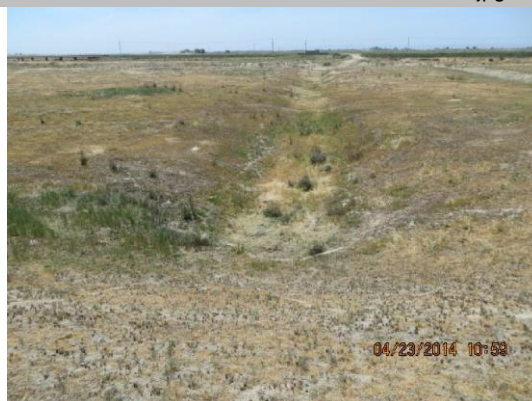
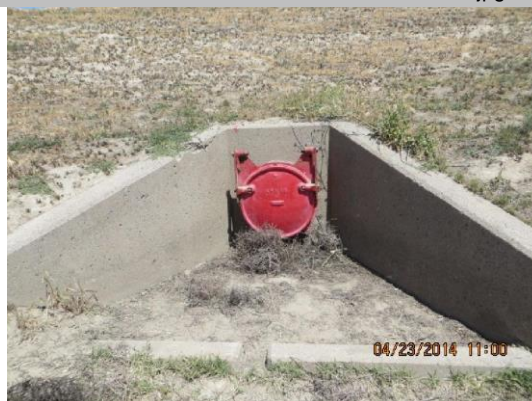
LM Start	<b>19.17</b>	Rating **	A/W	Issue No.	<b>50 (cont)</b>
LM End	<b>19.17</b>	Issue Type +	Ma	Location *	
Category	Supplemental			GPS Latitude/Longitude	
				Start	End
Item	DWR UCIP LMA Responsibility			37.115463 °	37.115463 °
				-120.565086 °	-120.565086 °
DWR ID	19776

FS\_ID:62468  
DS\_ID:19776  
EP\_NO: N/A  
Repair Type: No Action Needed  
Crossing Status: Found  
UCIP Comments:  
FIELD\_STRUCT\_DESC: 24-inch corrugated metal gravity drainage pipe through the levee, 10.3 feet below the crown. Flap gate on the waterside (WS) end. Concrete headwall on the landside (LS) end. Concrete U-shaped headwall on the WS end. [Additional Reference(s): DWR Levee Log, 2002 (HLM 19.15), listed as a 24-inch corrugated metal pipe (CMP). USACE San Joaquin O&M Manual, Unit 601 Part 1 (SJR601.1), 1967, Revised 25 May 2011, (HLM 19.15), listed as a 24-inch CMP]  
FS Date: 4/23/2014

Headwall, pipe, and flapgate visible on WS toe.

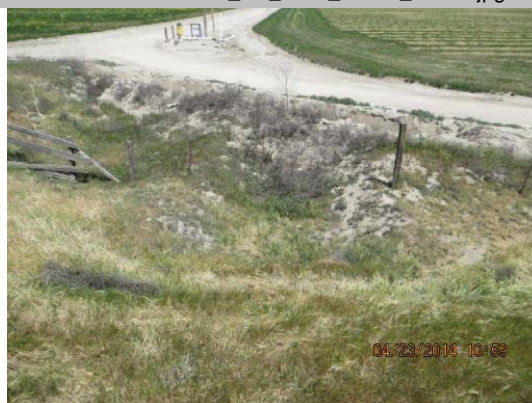
Photo 3 of 3 : UCIP\_SP\_2021\_62468\_62510.jpg

Headwall and pipe visible on LS toe.

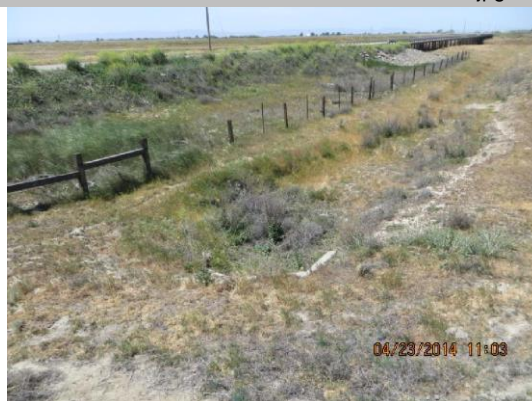
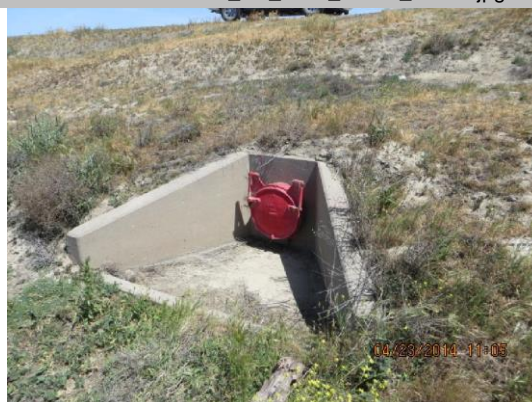
Photo 1 of 3 : UCIP\_SP\_2021\_62469\_62514.jpg

Comment Code						
Inspector Comment						
FS_ID:62469 DS_ID:19777 EP_NO: N/A Repair Type: Non-Urgent Crossing Status: Found UCIP Comments: 04/23/2014 Sediment buildup in pipe visible from landward side--recommend contacting owner to clear pipe. (W. Wylie - DWR UCIP) FIELD_STRUCT_DESC: 24-inch corrugated metal gravity drainage pipe through the levee, 9 feet below the crown. Flap gate on the waterside (WS) end. Concrete headwall on the landside (LS) end. Concrete U-shaped headwall on the WS end. [Additional Reference(s): DWR Levee Log, 2002 (HLM 19.46), listed as a 24-inch corrugated metal pipe (CMP). USACE San Joaquin O&M Manual, Unit 601 Part 1 (SJR601.1), 1967, Revised 25 May 2011, (HLM 19.46), listed as a 24-inch CMP] FS Date: 4/23/2014

Headwall, pipe, and flapgate visible on WS toe.

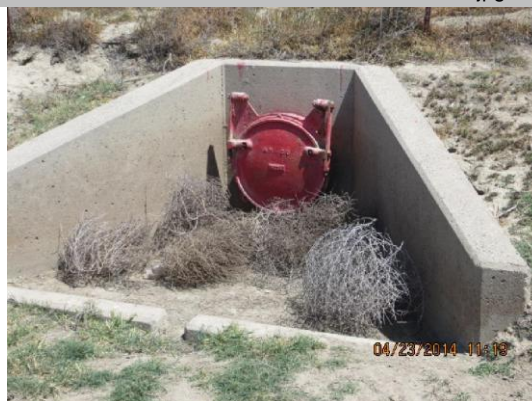
Photo 2 of 3 : UCIP\_SP\_2021\_62470\_62521.jpg

Headwall, pipe, and flapgate visible on WS toe.

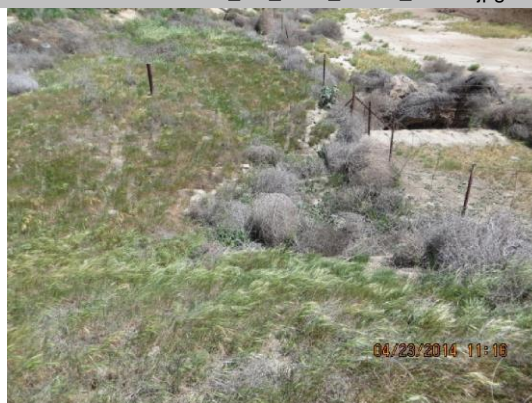
Photo 3 of 3 : UCIP\_SP\_2021\_62470\_62520.jpg

Headwall and pipe visible on LS toe.

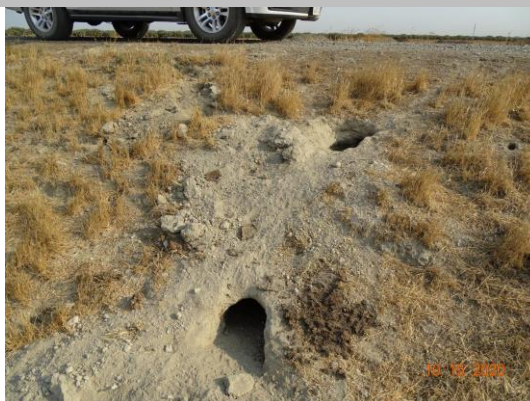
Photo 1 of 1 : SP\_2021\_NA0010\_123\_128\_20210308\_00023.jpg

LM Start	19.64	Rating **	U	Issue No.	128
LM End	19.64	Issue Type +	Ma	Location *	WS
Category	Earthen Levee			GPS Latitude/Longitude	
				Start	End
Item	Animal Control			37.111664 °	37.111664 °
				-120.558511 °	-120.558511 °
DWR ID	DWR_NA0010_05_f_2020_128				
Comment Code					
A3 : No rodents visible, but rodent burrows visible; need to backfill and compact or grout burrows.					
Inspector Comment

View of rodent activity on the waterside slope. (Fall 2020)

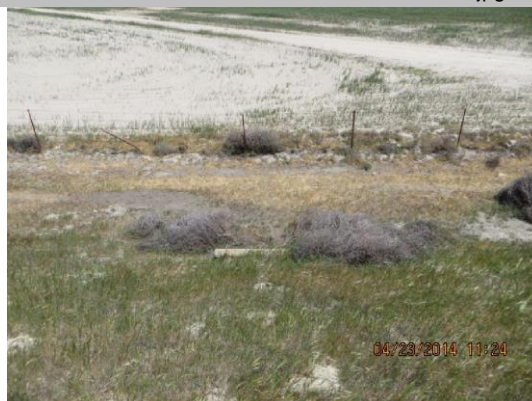
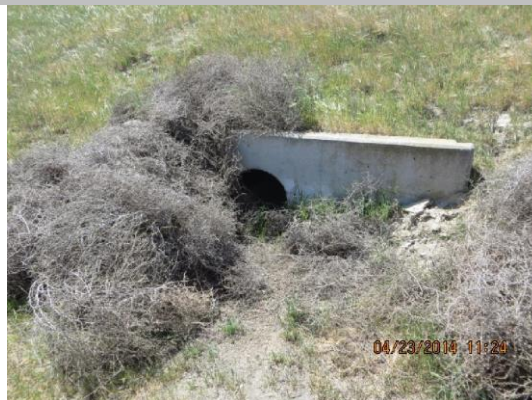
Photo 1 of 3 : UCIP\_SP\_2021\_62521\_62525.jpg

Headwall and pipe visible on LS toe.

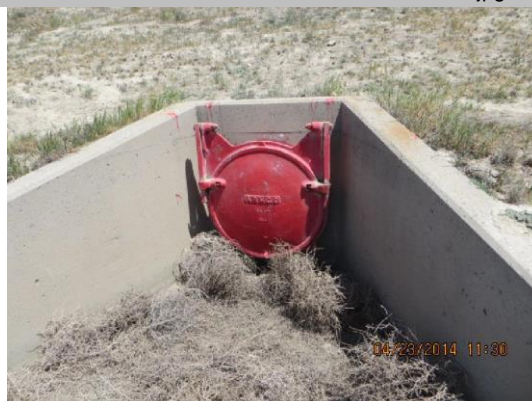
Photo 2 of 3 : UCIP\_SP\_2021\_62472\_62530.jpg

Headwall, pipe, and flapgate visible on WS toe.

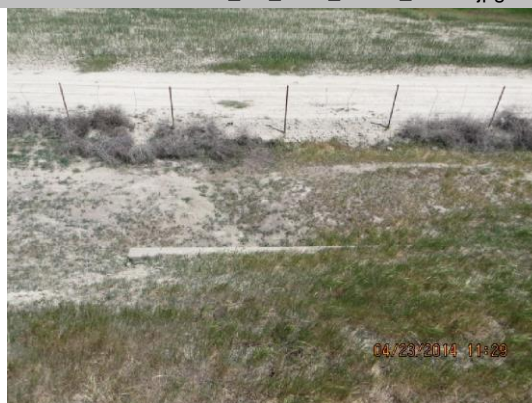
Photo 3 of 3 : UCIP\_SP\_2021\_62472\_62528.jpg

Headwall and pipe visible on LS toe.

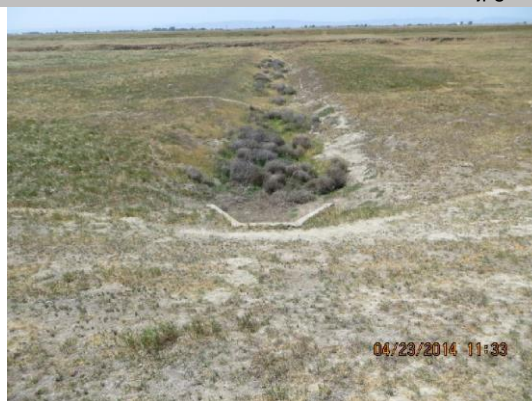
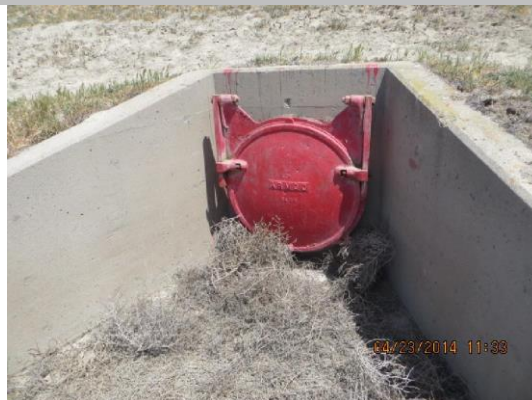
Photo 1 of 3 : UCIP\_SP\_2021\_62522\_62533.jpg

Headwall, pipe, and flapgate visible on WS toe.

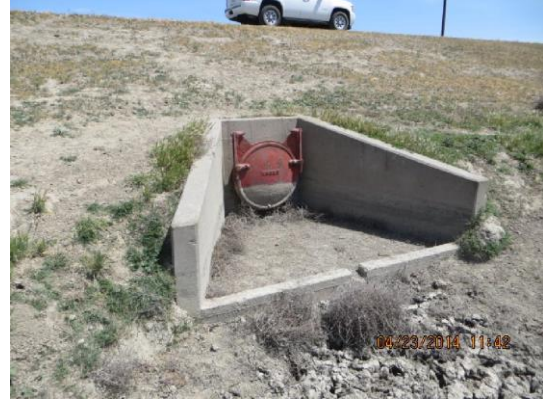
Photo 2 of 3 : UCIP\_SP\_2021\_62474\_62541.jpg

Headwall, pipe, and flapgate visible on WS toe.

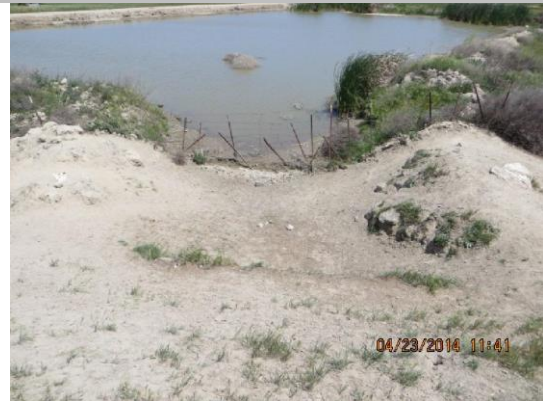
Photo 3 of 3 : UCIP\_SP\_2021\_62474\_62540.jpg

Headwall and pipe visible on LS toe.

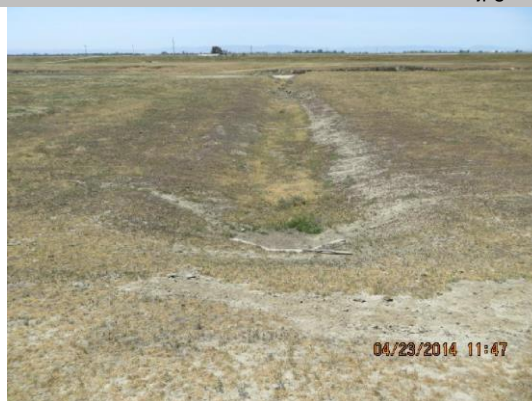
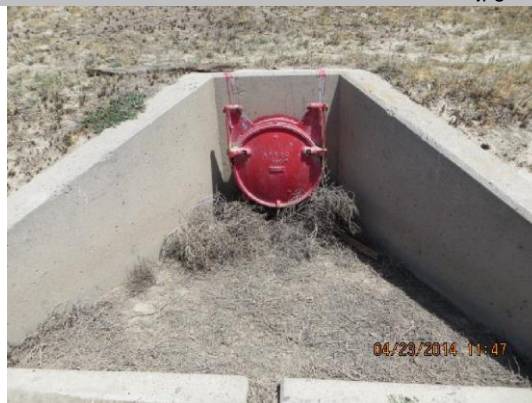
Photo 1 of 3 : UCIP\_SP\_2021\_62523\_62544.jpg

Comment Code					
Inspector Comment					
FS_ID:62523 DS_ID:19784 EP_NO: N/A Repair Type: Non-Urgent Crossing Status: Found UCIP Comments: 04/23/2014 Dense vegetation limits the inspector's visibility to identify signs of pipe failure (leaks) along the landward slope. Recommend removing vegetation along pipe alignment to conduct proper inspection of structure. (W. Wylie - DWR UCIP) FIELD_STRUCT_DESC: 24-inch corrugated metal gravity drainage pipe through the levee, 10.5 feet below the crown. Flap gate on the waterside (WS) end. Concrete headwall on the landside (LS) end. Concrete U-shaped headwall on the WS end. [Additional Reference(s): DWR Levee Log, 2002 (HLM 20.58), listed as a 24-inch corrugated metal pipe (CMP). USACE San Joaquin O&M Manual, Unit 601 Part 1 (SJR601.1), 1967, Revised 25 May 2011, (HLM 20.59), listed as a 24-inch CMP] FS Date: 4/23/2014

Headwall, pipe, and flapgate visible on WS toe.

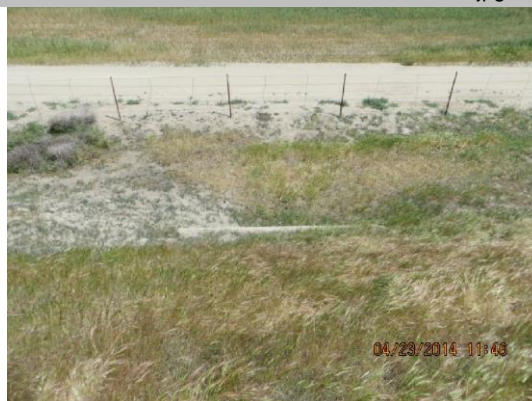
Photo 3 of 3 : UCIP\_SP\_2021\_62523\_62545.jpg

Headwall and pipe visible on LS toe.

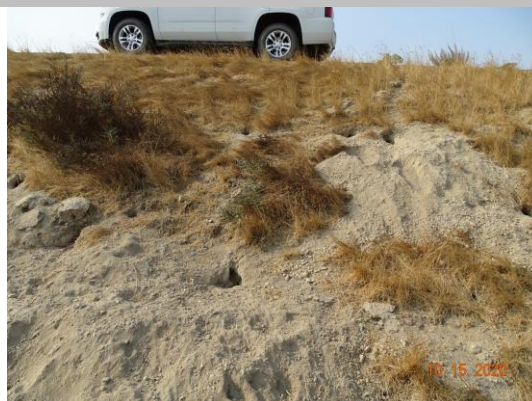
Photo 1 of 1 : SP\_2021\_NA0010\_123\_135\_20210308\_00028.jpg

LM Start	20.93	Rating **	M	Issue No.	135
LM End	20.93	Issue Type +	Ma	Location *	LS
Category	Earthen Levee			GPS Latitude/Longitude	
				Start	End
Item	Animal Control			37.097826 °	37.097826 °
				-120.543984 °	-120.543984 °
DWR ID	DWR_NA0010_05_f_2020_135				
Comment Code					
A3 : No rodents visible, but rodent burrows visible; need to backfill and compact or grout burrows.					
Inspector Comment

View of rodent burrow in the landside slope. (Fall 2020)

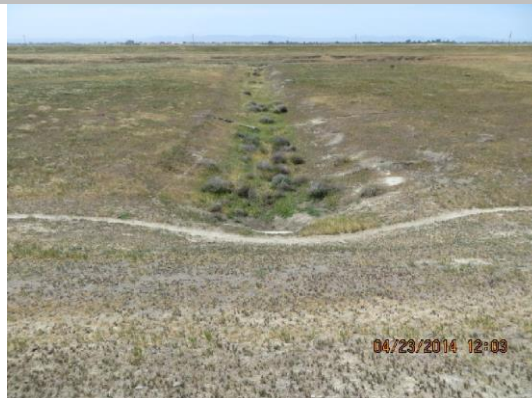
Photo 1 of 3 : UCIP\_SP\_2021\_62476\_62549.jpg

FS\_ID:62476  
DS\_ID:19785  
EP\_NO: N/A  
Repair Type: Non-Urgent  
Crossing Status: Found  
UCIP Comments: 04/23/2014 Dense vegetation limits the inspector's visibility to identify signs of pipe failure (leaks) along the landward slope. Recommend removing vegetation along pipe alignment to conduct proper inspection of structure. (W. Wylie - DWR UCIP)  
FIELD\_STRUCT\_DESC: 24-inch corrugated metal gravity drainage pipe through the levee, 11.8 feet below the crown. Flap gate on the waterside (WS) end. Concrete headwall on the landside (LS) end. Concrete U-shaped headwall on the WS end. [Additional Reference(s): DWR Levee Log, 2002 (HLM 21.07), listed as a 24-inch corrugated metal pipe (CMP). USACE San Joaquin O&M Manual, Unit 601 Part 1 (SJR601.1), 1967, Revised 25 May 2011, (HLM 21.08), listed as a 24-inch CMP]  
FS Date: 4/23/2014

Headwall, pipe, and flapgate visible on WS toe.

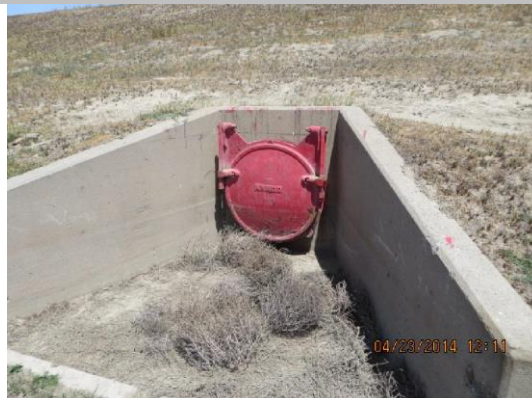
Photo 2 of 3 : UCIP\_SP\_2021\_62524\_62556.jpg

Headwall, pipe, and flapgate visible on WS toe.

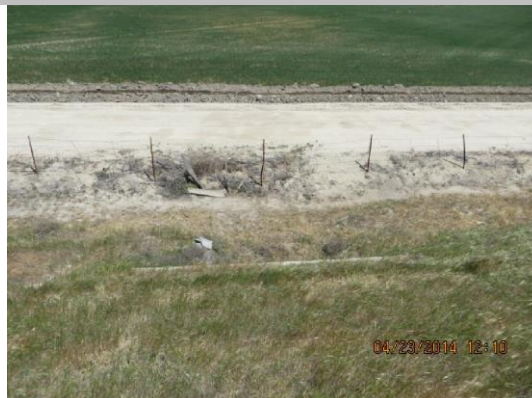
Photo 3 of 3 : UCIP\_SP\_2021\_62524\_62554.jpg

Headwall and pipe visible on LS toe.

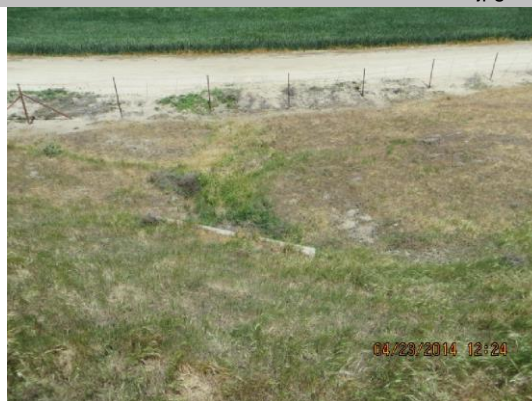
Photo 3 of 3 : UCIP\_SP\_2021\_62478\_62560.jpg

Headwall and pipe visible on LS toe.

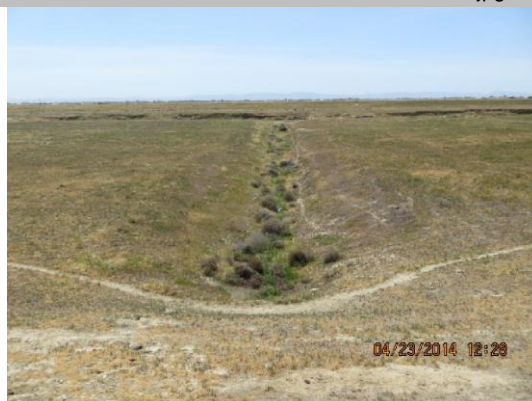
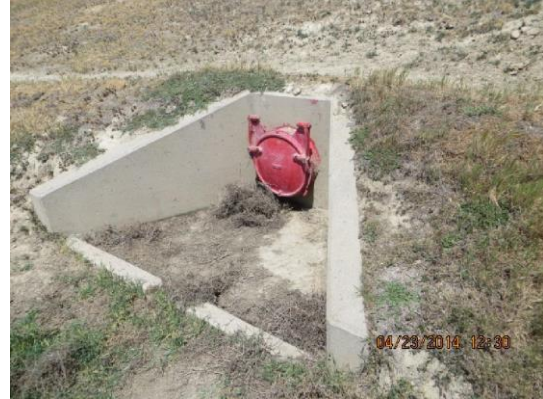
Photo 1 of 3 : UCIP\_SP\_2021\_62479\_62586.jpg

FS\_ID:62479  
DS\_ID:19788  
EP\_NO: N/A  
Repair Type: Non-Urgent  
Crossing Status: Found  
UCIP Comments: 04/23/2014 Dense vegetation limits the inspector's visibility to identify signs of pipe failure (leaks) along the landward slope. Recommend removing vegetation along pipe alignment to conduct proper inspection of structure. (W. Wylie - DWR UCIP)  
FIELD\_STRUCT\_DESC: 24-inch corrugated metal gravity drainage pipe through the levee, 10.7 feet below the crown. Flap gate on the waterside (WS) end. Concrete headwall on the landside (LS) end. Concrete U-shaped headwall on the WS end. [Additional Reference(s): DWR Levee Log, 2002 (HLM 21.85), listed as a 24-inch corrugated metal pipe (CMP). USACE San Joaquin O&M Manual, Unit 601 Part 1 (SJR601.1), 1967, Revised 25 May 2011, (HLM 21.85), listed as a 24-inch CMP].  
FS Date: 4/23/2014

Headwall, pipe, and flapgate visible on WS toe.

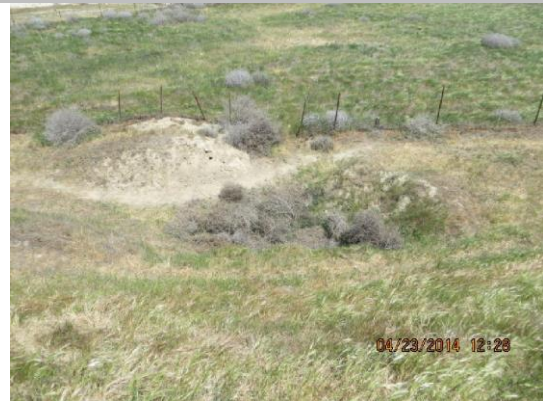
Photo 3 of 3 : UCIP\_SP\_2021\_62479\_62587.jpg

Headwall and pipe visible on LS toe.

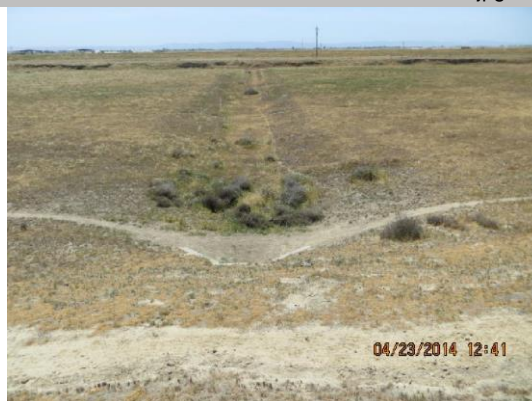
Photo 1 of 3 : UCIP\_SP\_2021\_62480\_62591.jpg

Comment Code					
Inspector Comment					
FS_ID:62480 DS_ID:19789 EP_NO: N/A Repair Type: Non-Urgent Crossing Status: Found UCIP Comments: 04/23/2014 Dense vegetation limits the inspector's visibility to identify signs of pipe failure (leaks) along the landward slope. Recommend removing vegetation along pipe alignment to conduct proper inspection of structure. Sediment buildup in pipe visible from landward side--recommend contacting owner to clear pipe. (W. Wylie - DWR UCIP) FIELD_STRUCT_DESC: 24-inch corrugated metal gravity drainage pipe through the levee, 10.2 feet below the crown. Flap gate on the waterside (WS) end. Concrete headwall on the landside (LS) end. Concrete U-shaped headwall on the WS end. [Additional Reference(s): DWR Levee Log, 2002 (HLM 22.18), listed as a 24-inch corrugated metal pipe (CMP). USACE San Joaquin O&M Manual, Unit 601 Part 1 (SJR601.1), 1967, Revised 25 May 2011, (HLM 22.19), listed as a 24-inch CMP]. FS Date: 4/23/2014

Headwall, pipe, and flapgate visible on WS toe.

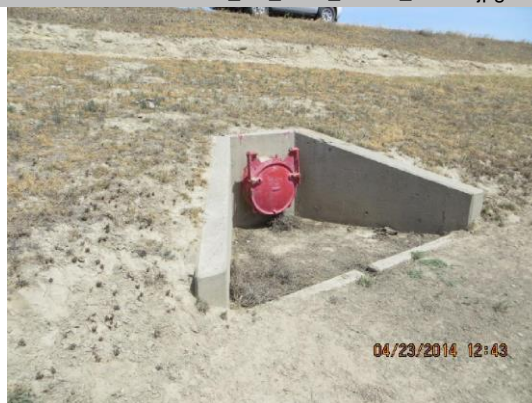
Photo 2 of 3 : UCIP\_SP\_2021\_62480\_62593.jpg

Headwall, pipe, and flapgate visible on WS toe.

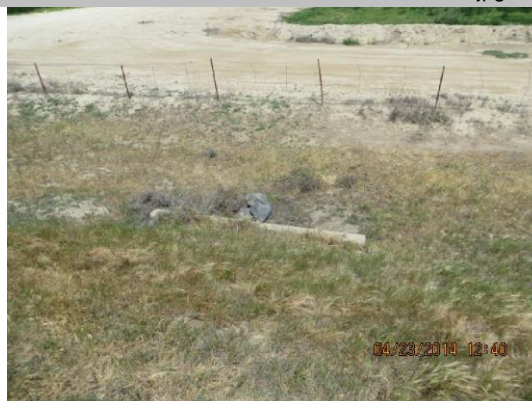
Photo 3 of 3 : UCIP\_SP\_2021\_62480\_62592.jpg

Headwall and pipe visible on LS toe.

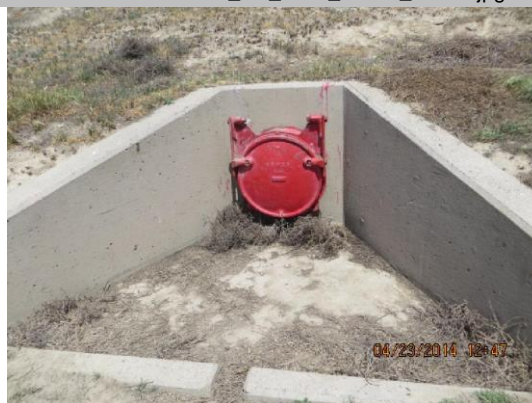
Photo 2 of 3 : UCIP\_SP\_2021\_62481\_62598.jpg

Comment Code					
Inspector Comment					
FS_ID:62481 DS_ID:19790 EP_NO: N/A Repair Type: Non-Urgent Crossing Status: Found UCIP Comments: 04/23/2014 Dense vegetation limits the inspector's visibility to identify signs of pipe failure (leaks) along the landward slope. Recommend removing vegetation along pipe alignment to conduct proper inspection of structure. Sediment buildup in pipe visible from landward side--recommend contacting owner to clear pipe. (W. Wylie - DWR UCIP) FIELD_STRUCT_DESC: 24-inch corrugated metal gravity drainage pipe through the levee, 10.4 feet below the crown. Flap gate on the waterside (WS) end. Concrete headwall on the landside (LS) end. Concrete U-shaped headwall on the WS end. [Additional Reference(s): DWR Levee Log, 2002 (HLM 22.46), listed as a 24-inch corrugated metal pipe (CMP). USACE San Joaquin O&M Manual, Unit 601 Part 1 (SJR601.1), 1967, Revised 25 May 2011, (HLM 22.46), listed as a 24-inch CMP] FS Date: 4/23/2014

Headwall, pipe, and flapgate visible on WS toe.

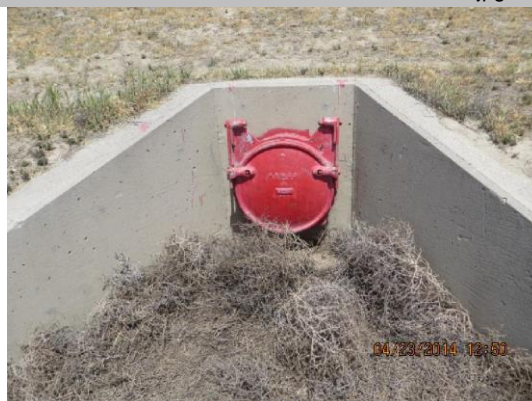
Photo 2 of 3 : UCIP\_SP\_2021\_62482\_62600.jpg

Headwall, pipe, and flapgate visible on WS toe.

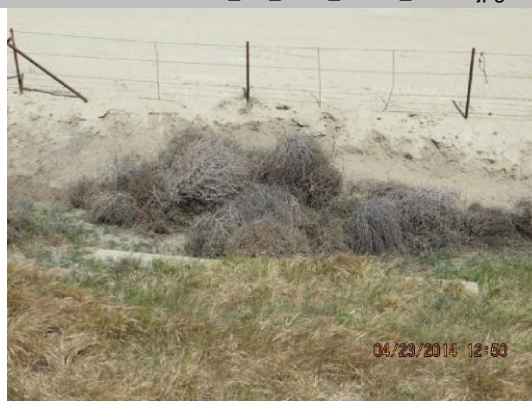
Photo 3 of 3 : UCIP\_SP\_2021\_62482\_62602.jpg

Headwall and pipe visible on LS toe.

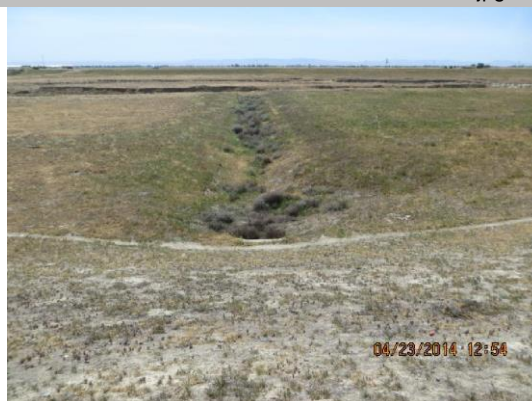
Photo 1 of 3 : UCIP\_SP\_2021\_62483\_62606.jpg

FS\_ID:62483  
DS\_ID:19792  
EP\_NO: N/A  
Repair Type: Non-Urgent  
Crossing Status: Found  
UCIP Comments: 04/23/2014 Dense vegetation limits the inspector's visibility to identify signs of pipe failure (leaks) along the landward slope. Recommend removing vegetation along pipe alignment to conduct proper inspection of structure. (W. Wylie - DWR UCIP)  
FIELD\_STRUCT\_DESC: 24-inch corrugated metal gravity drainage pipe through the levee, 11.1 feet below the crown. Flap gate on the waterside (WS) end. Concrete headwall on the landside (LS) end. Concrete U-shaped headwall on the WS end. [Additional Reference(s): DWR Levee Log, 2002 (HLM 22.93), listed as a 24-inch corrugated metal pipe (CMP). USACE San Joaquin O&M Manual, Unit 601 Part 1 (SJR601.1), 1967, Revised 25 May 2011, (HLM 22.94), listed as a 24-inch CMP]  
FS Date: 4/23/2014

Headwall, pipe, and flapgate visible on WS toe.

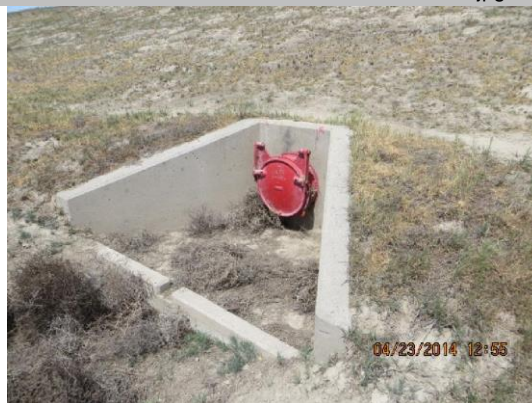
Photo 2 of 3 : UCIP\_SP\_2021\_62483\_62608.jpg

Headwall, pipe, and flapgate visible on WS toe.

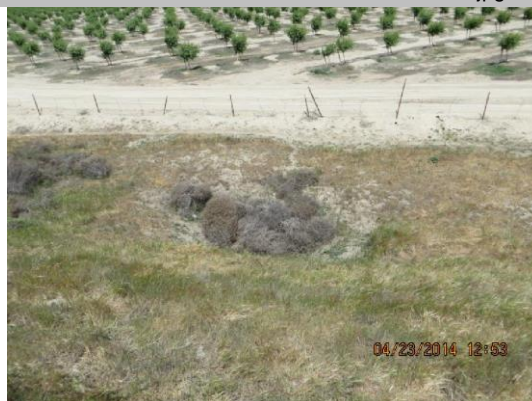
Photo 3 of 3 : UCIP\_SP\_2021\_62483\_62607.jpg

Headwall and pipe visible on LS toe.

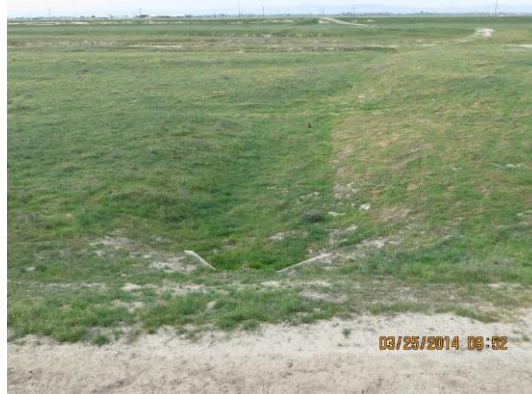
Photo 1 of 3 : UCIP\_SP\_2021\_62485\_59262.jpg

Comment Code						
Inspector Comment						
FS_ID:62485						
DS_ID:19794						
EP_NO: N/A						
Repair Type: No Action Needed						
Crossing Status: Found						
UCIP Comments:						
FIELD_STRUCT_DESC: 30-inch corrugated metal gravity drainage pipe through the levee, 11.6 feet below the crown. Flap gate on the waterside (WS) end. Concrete headwall on the landside (LS) end. Concrete U-shaped headwall on the WS end. [Additional Reference(s): DWR Levee Log, 2002 (HLM 23.14), listed as a 30-inch corrugated metal pipe (CMP). USACE San Joaquin O&M Manual, Unit 601 Part 1 (SJR601.1), 1967, Revised 25 May 2011, (HLM 23.15), listed as a 30-inch CMP]						
FS Date: 3/25/2014 9:04:00 AM

Concrete headwall on WS toe.

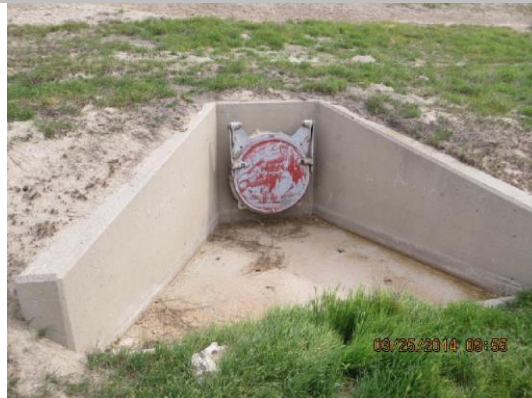
Photo 2 of 3 : UCIP\_SP\_2021\_62485\_59263.jpg

Flapgate and concrete headwall on WS toe.

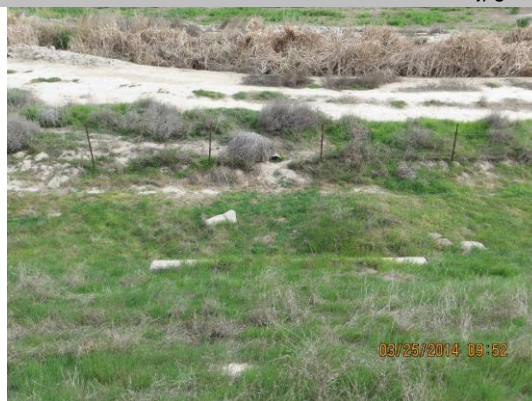
Photo 3 of 3 : UCIP\_SP\_2021\_62485\_59261.jpg

Concrete headwall on LS toe.

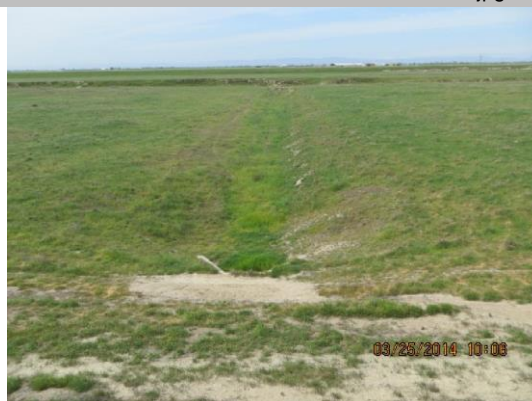
Photo 1 of 3 : UCIP\_SP\_2021\_62488\_59272.jpg

FS\_ID:62488  
 DS\_ID:19796  
 EP\_NO: N/A  
 Repair Type: Non-Urgent  
 Crossing Status: Found  
 UCIP Comments: 03/25/2014 Sediment buildup in pipe visible from landward side--recommend contacting owner to clear pipe. (W. Wylie - DWR UCIP)  
 FIELD\_STRUCT\_DESC: 30-inch corrugated metal gravity drainage pipe through the levee, 12.1 feet below the crown. Flap gate on the waterside (WS) end. Concrete U-shaped headwall on the WS end.  
 [Additional Reference(s): DWR Levee Log, 2002 (HLM 23.61), listed as a 30-inch corrugated metal pipe (CMP). USACE San Joaquin O&M Manual, Unit 601 Part 1 (SJR601.1), 1967, Revised 25 May 2011, (HLM 23.62), listed as a 30-inch CMP]  
 FS Date: 3/25/2014

Concrete headwall on WS toe.

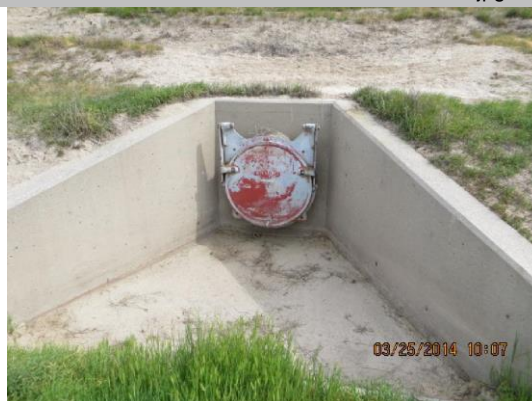
Photo 2 of 3 : UCIP\_SP\_2021\_62488\_59270.jpg

Flapgate on Concrete headwall on WS toe.

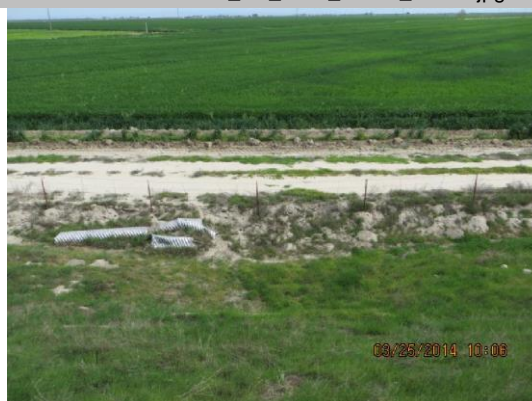
Photo 3 of 3 : UCIP\_SP\_2021\_62488\_59271.jpg

Concrete headwall on LS toe.

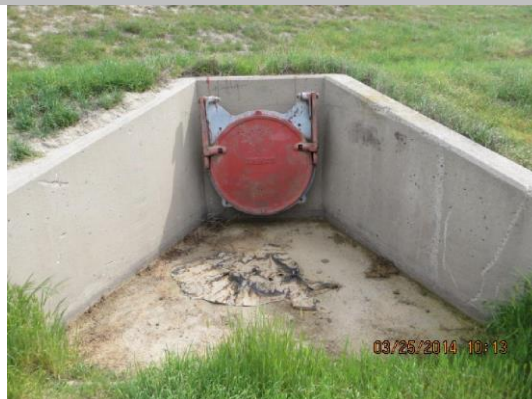
Photo 2 of 3 : UCIP\_SP\_2021\_62489\_59280.jpg

Comment Code						
Inspector Comment						
FS_ID:62489 DS_ID:19797 EP_NO: N/A Repair Type: Non-Urgent Crossing Status: Found UCIP Comments: 03/25/2014 Minor sediment/debris buildup in pipe visible from landward side--recommend contacting owner to clear pipe. (W. Wylie - DWR UCIP) FIELD_STRUCT_DESC: 36-inch corrugated metal gravity drainage pipe through the levee, 12.1 feet below the crown. Flap gate on the waterside (WS) end. Concrete headwall on the landside (LS) end. Concrete U-shaped headwall on the WS end. [Additional Reference(s): DWR Levee Log, 2002 (HLM 23.92), listed as a 36-inch corrugated metal pipe (CMP). USACE San Joaquin O&M Manual, Unit 601 Part 1 (SJR601.1), 1967, Revised 25 May 2011, (HLM 23.85), listed as a 36-inch CMP] FS Date: 3/25/2014

Flapgate at Concrete headwall on WS toe.

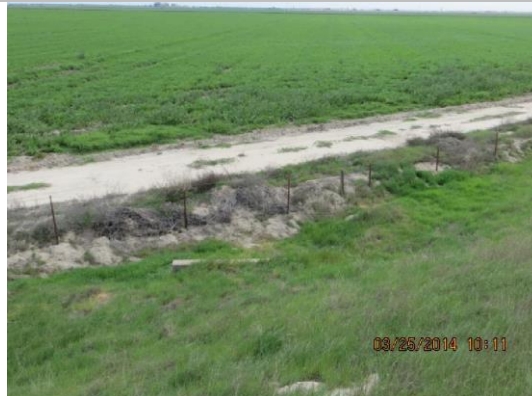
Photo 3 of 3 : UCIP\_SP\_2021\_62489\_59281.jpg

Concrete headwall on LS toe.

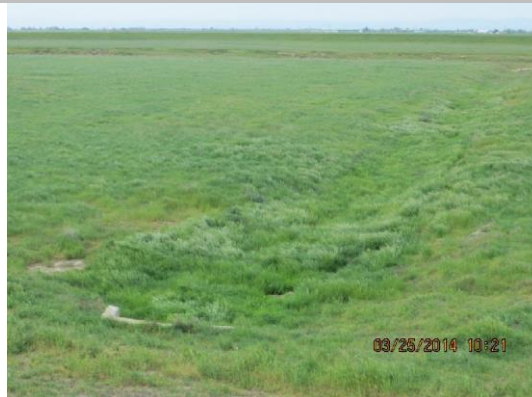
Photo 1 of 3 : UCIP\_SP\_2021\_62490\_59287.jpg

FS\_ID:62490  
DS\_ID:19798  
EP\_NO: N/A  
Repair Type: Non-Urgent  
Crossing Status: Found  
UCIP Comments: 03/25/2014 Dense vegetation limits the inspector's visibility to identify signs of pipe failure (leaks) along the landward slope. Recommend removing vegetation along pipe alignment to conduct proper inspection of structure. (W. Wylie - DWR UCIP)  
FIELD\_STRUCT\_DESC: 24-inch corrugated metal gravity drainage pipe through the levee, 11.2 feet below the crown. Flap gate on the waterside (WS) end. Concrete headwall on the landside (LS) end. Concrete U-shaped headwall on the WS end. [Additional Reference(s): DWR Levee Log, 2002 (HLM 24.18), listed as a 24-inch corrugated metal pipe (CMP). USACE San Joaquin O&M Manual, Unit 601 Part 1 (SJR601.1), 1967, Revised 25 May 2011, (HLM 24.18), listed as a 24-inch CMP]  
FS Date: 3/25/2014

Concrete headwall at WS toe.

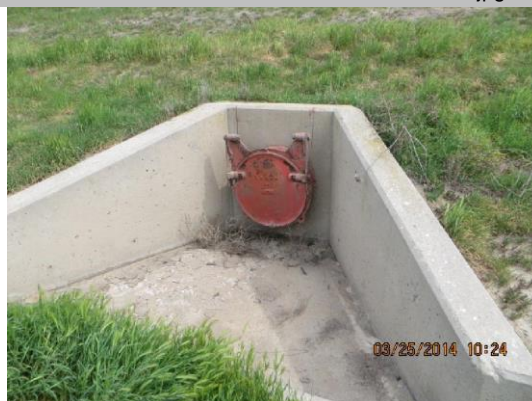
Photo 2 of 3 : UCIP\_SP\_2021\_62490\_59285.jpg

Flapgate at concrete headwall at WS toe.

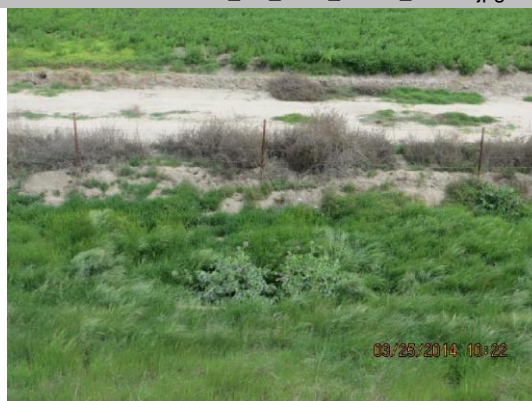
Photo 3 of 3 : UCIP\_SP\_2021\_62490\_59286.jpg

Concrete headwall at LS toe.

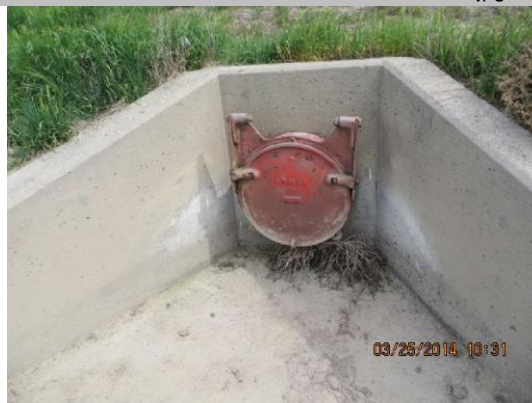
Photo 2 of 3 : UCIP\_SP\_2021\_62491\_59290.jpg

FS\_ID:62491  
DS\_ID:19799  
EP\_NO: N/A  
Repair Type: Non-Urgent  
Crossing Status: Found  
UCIP Comments: 03/25/2014 Dense vegetation limits the inspector's visibility to identify signs of pipe failure (leaks) along the landward slope. Recommend removing vegetation along pipe alignment to conduct proper inspection of structure. (W. Wylie - DWR UCIP)  
FIELD\_STRUCT\_DESC: 24-inch corrugated metal gravity drainage pipe through the levee, 11.2 feet below the crown. Flap gate on the waterside (WS) end. Concrete headwall on the landside (LS) end. Concrete U-shaped headwall on the WS end. [Additional Reference(s): DWR Levee Log, 2002 (HLM 24.46), listed as a 24-inch corrugated metal pipe (CMP). USACE San Joaquin O&M Manual, Unit 601 Part 1 (SJR601.1), 1967, Revised 25 May 2011, (HLM 24.46), listed as a 24-inch CMP]  
FS Date: 3/25/2014

Flapgate at Concrete headwall on WS toe.

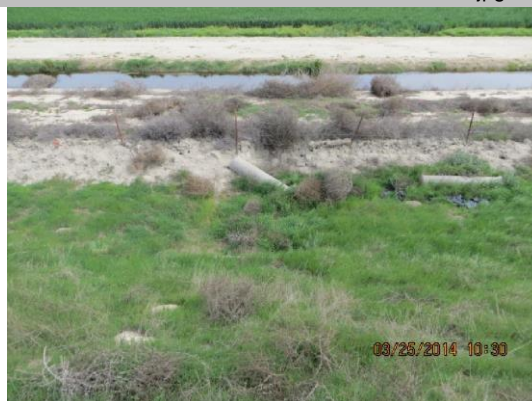
Photo 3 of 3 : UCIP\_SP\_2021\_62491\_59291.jpg

Concrete headwall on LS toe.

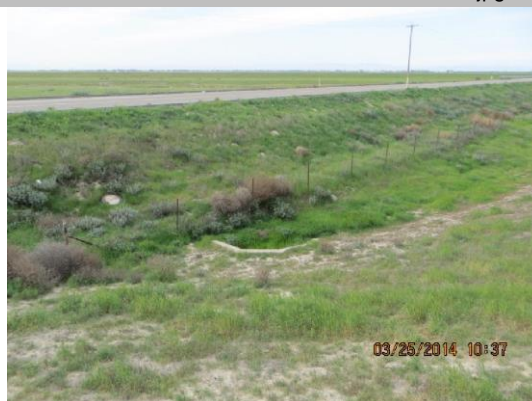
Photo 1 of 3 : UCIP\_SP\_2021\_62492\_59297.jpg

FS\_ID:62492  
 DS\_ID:19800  
 EP\_NO: N/A  
 Repair Type: No Action Needed  
 Crossing Status: Found  
 UCIP Comments:  
 FIELD\_STRUCT\_DESC: 24-inch corrugated metal gravity drainage pipe through the levee, 10.7 feet below the crown. Flap gate on the waterside (WS) end. Concrete headwall on the landside (LS) end. Concrete U-shaped headwall on the WS end. [Additional Reference(s): DWR Levee Log, 2002 (HLM 24.82), listed as a 24-inch corrugated metal pipe (CMP). USACE San Joaquin O&M Manual, Unit 601 Part 1 (SJR601.1), 1967, Revised 25 May 2011, (HLM 24.82), listed as a 24-inch CMP]  
 FS Date: 3/25/2014

Concrete headwall on WS toe.

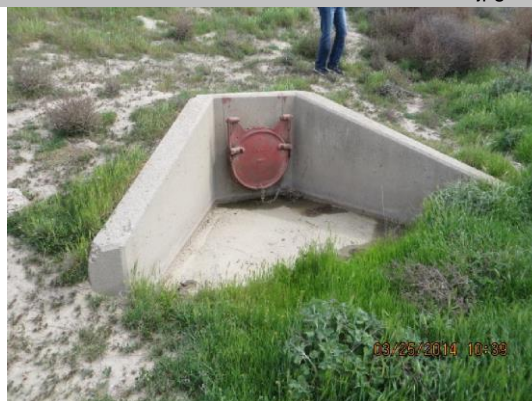
Photo 2 of 3 : UCIP\_SP\_2021\_62492\_59295.jpg

Flapgate on concrete headwall on WS toe.

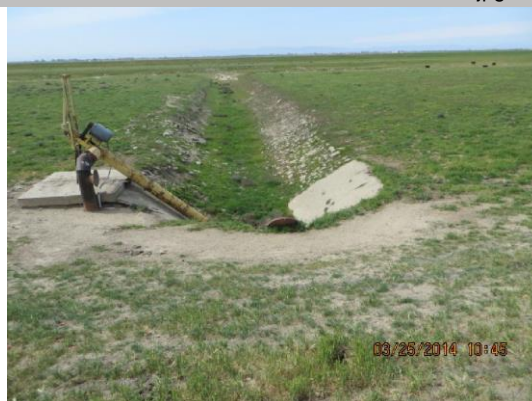
Photo 1 of 3 : UCIP\_SP\_2021\_62493\_59302.jpg

Flapgate and channel off WS toe.

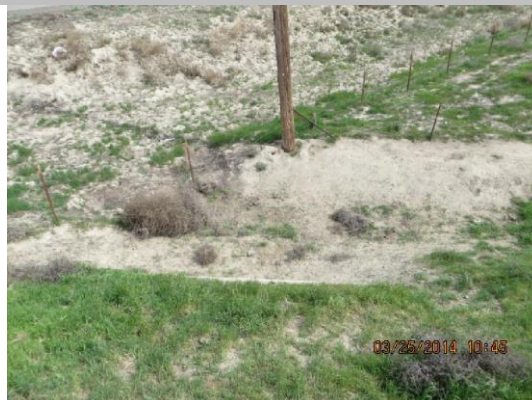
Photo 2 of 3 : UCIP\_SP\_2021\_62493\_59301.jpg

Concrete headwall on LS toe.

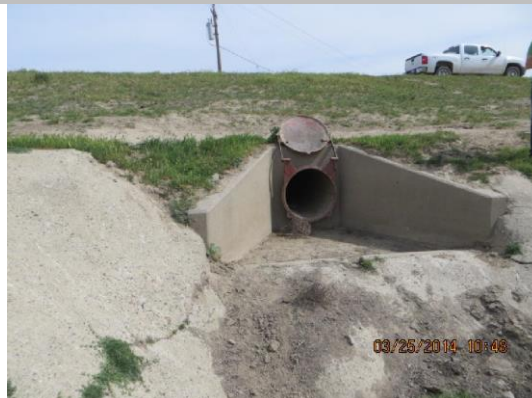
Photo 3 of 3 : UCIP\_SP\_2021\_62493\_59303.jpg

Flapgate on headwall at WS toe.

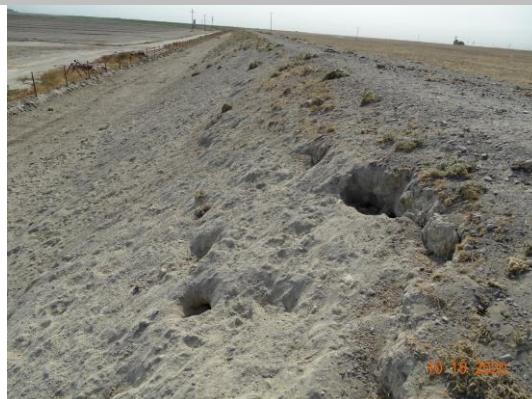
Photo 1 of 1 : SP\_2021\_NA0010\_123\_123\_20210308\_00019.jpg

LM Start	25.09	Rating **	A/W	Issue No.	123
LM End	25.26	Issue Type +	Ma	Location *	LS
Category	Earthen Levee			GPS Latitude/Longitude	
				Start	End
Item	Animal Control			37.053103 °	37.051252 °
				-120.494651 °	-120.492368 °
DWR ID	DWR_NA0010_05_f_2017_123				
Comment Code					
A1 : Exterminate rodents and backfill and compact or grout burrows.					
Inspector Comment

View of the landside slope looking upstream. (Fall 2020)

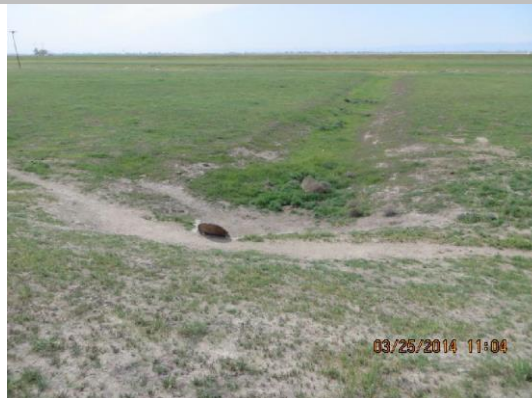
Photo 1 of 3 : UCIP\_SP\_2021\_62518\_59311.jpg

Comment Code					
Inspector Comment					
FS_ID:62518 DS_ID:19803 EP_NO: N/A Repair Type: Non-Urgent Crossing Status: Found UCIP Comments: 03/25/2014 Flapgate propped open during flood season. (W. Wylie - DWR UCIP) FIELD_STRUCT_DESC: 30-inch corrugated metal gravity drainage pipe through the levee, 11.3 feet below the crown. Flap gate on the waterside (WS) end. Concrete headwall on the landside (LS) end. Concrete U-shaped headwall on the WS end. [Additional Reference(s): DWR Levee Log, 2002 (HLM 25.14), listed as a 30-inch corrugated metal pipe (CMP). USACE San Joaquin O&M Manual, Unit 601 Part 1 (SJR601.1), 1967, Revised 25 May 2011, (recorded incorrectly as HLM 25.43 correct HLM 25.13), listed as a 30-inch CMP] FS Date: 10/27/2020 2:27:00 PM

Concrete headwall and flapgate on WS toe.

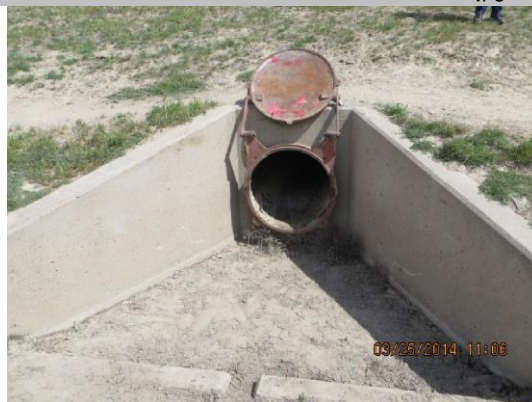
Photo 2 of 3 : UCIP\_SP\_2021\_62518\_59312.jpg

Concrete headwall and flapgate on WS toe.

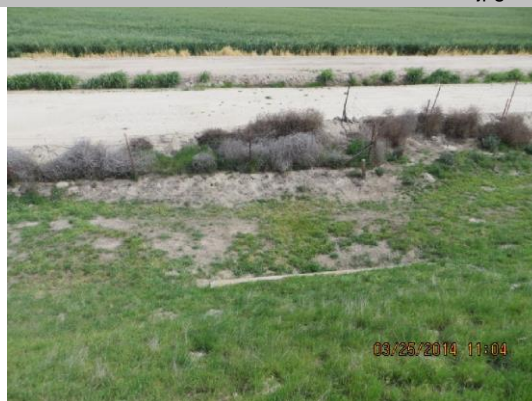
Photo 3 of 3 : UCIP\_SP\_2021\_62518\_59310.jpg

Concrete headwall on LS toe.

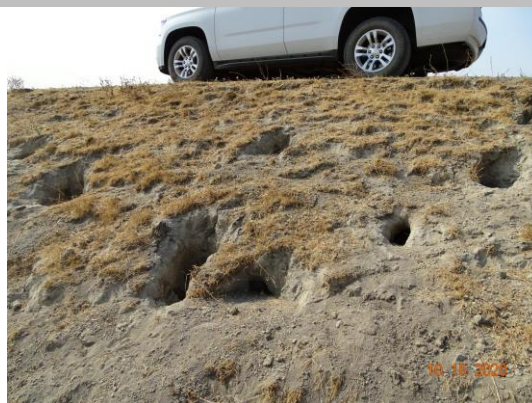
Photo 1 of 1 : SP\_2021\_NA0010\_123\_148\_20210308\_00037.jpg

LM Start	25.58	Rating **	U	Issue No.	148
LM End	25.60	Issue Type +	Ma	Location *	LS
Category	Earthen Levee			GPS Latitude/Longitude	
				Start	End
Item	Animal Control			37.047827 °	37.047551 °
				-120.488738 °	-120.488527 °
DWR ID	DWR_NA0010_05_f_2020_148				
Comment Code					
A3 : No rodents visible, but rodent burrows visible; need to backfill and compact or grout burrows.					
Inspector Comment

View of burrows in the landside. (Fall 2020)
