**Flood Control Project Maintenance  
Levee Inspections**

## Maintenance Issue Types Only, Levee Inspection Report By Mile - Spring 2021

### Lower San Joaquin Levee District

Waterway	Bank	Unit Miles	Inspection Start/End	Inspector
Unit No. 01 San Joaquin River	Right	22.52	05/04/2021 05/04/2021	Corey Fujitani

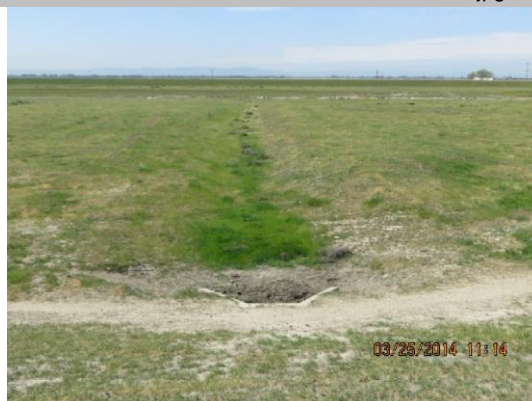
Photo 1 of 3 : UCIP\_SP\_2021\_62496\_59316.jpg

Comment Code					
Inspector Comment					
FS_ID:62496 DS_ID:19804 EP_NO: N/A Repair Type: Non-Urgent Crossing Status: Found UCIP Comments: 03/25/2014 Dense vegetation limits the inspector's visibility to identify signs of pipe failure (leaks) along the landward slope. Recommend removing vegetation along pipe alignment to conduct proper inspection of structure. Sediment buildup in pipe visible from landward side--recommend contacting owner to clear pipe. (W. Wylie - DWR UCIP) FIELD_STRUCT_DESC: 30-inch corrugated metal gravity drainage pipe through the levee, 12 feet below the crown. Flap gate on the waterside (WS) end. Concrete headwall on the landside (LS) end. Concrete U-shaped headwall on the WS end. [Additional Reference(s): DWR Levee Log, 2002 (HLM 25.51), listed as a 30-inch corrugated metal pipe (CMP). USACE San Joaquin O&M Manual, Unit 601 Part 1 (SJR601.1), 1967, Revised 25 May 2011, (HLM 25.51), listed as a 30-inch CMP] FS Date: 3/25/2014

Concrete headwall on WS toe.

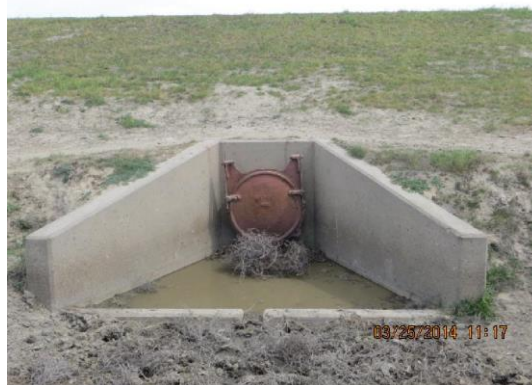
Photo 2 of 3 : UCIP\_SP\_2021\_62496\_59317.jpg

Flapgate on concrete headwall at WS toe.

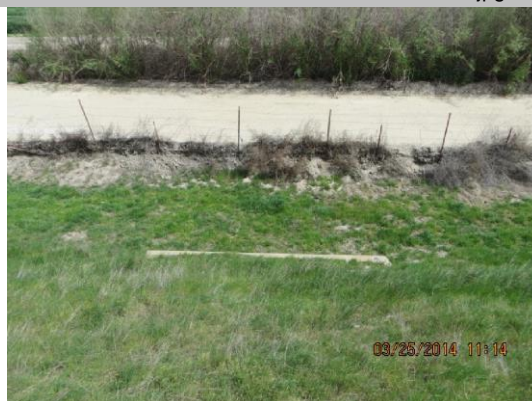
Photo 3 of 3 : UCIP\_SP\_2021\_62496\_59315.jpg

Concrete headwall on LS toe.

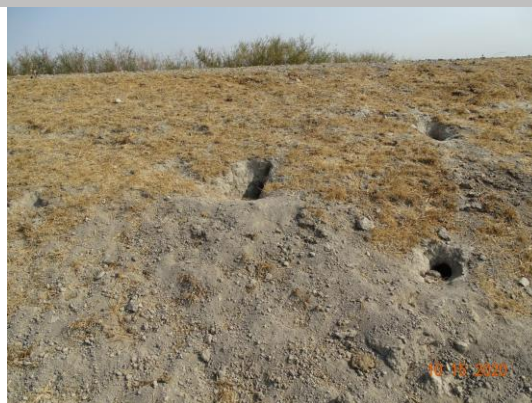
Photo 1 of 1 : SP\_2021\_NA0010\_123\_124\_20210308\_00020.jpg

LM Start	25.61	Rating **	M	Issue No.	124
LM End	25.61	Issue Type +	Ma	Location *	WS
Category	Earthen Levee			GPS Latitude/Longitude	
				Start	End
Item	Animal Control			37.047416 °	37.047416 °
				-120.488411 °	-120.488411 °
DWR ID	DWR_NA0010_05_f_2017_124				
Comment Code					
A1 : Exterminate rodents and backfill and compact or grout burrows.					
Inspector Comment

Looking east at the waterside slope. (Fall 2020)

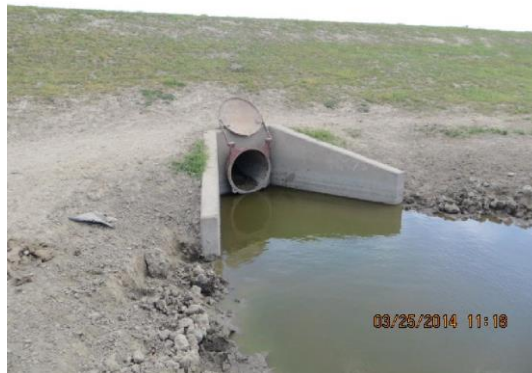
Photo 1 of 3 : UCIP\_SP\_2021\_62497\_59321.jpg

Comment Code						
Inspector Comment						
FS_ID:62497						
DS_ID:19805						
EP_NO: N/A						
Repair Type: Non-Urgent						
Crossing Status: Found						
UCIP Comments: 03/25/2014 Sediment buildup in pipe visible from landward side--recommend contacting owner to clear pipe. (W. Wylie - DWR UCIP)						
FIELD_STRUCT_DESC: 30-inch corrugated metal gravity drainage pipe through the levee, 12.1 feet below the crown. Flap gate on the waterside (WS) end. Concrete headwall on the landside (LS) end. Concrete U-shaped headwall on the WS end. [Additional Reference(s): DWR Levee Log, 2002 (HLM 25.53), listed as a 30-inch corrugated metal pipe (CMP). USACE San Joaquin O&M Manual, Unit 601 Part 1 (SJR601.1), 1967, Revised 25 May 2011, (HLM 25.53), listed as a 30-inch CMP]						
FS Date: 3/25/2014

Flapgate on headwall at WS toe.

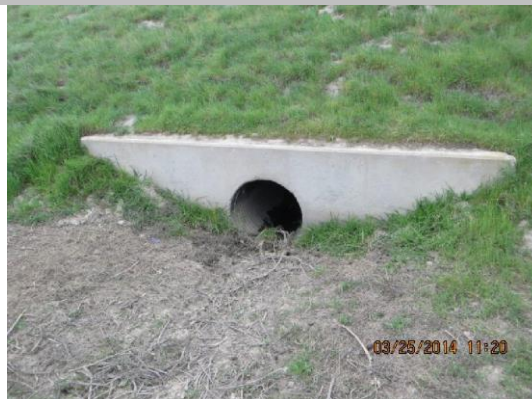
Photo 2 of 3 : UCIP\_SP\_2021\_62497\_59320.jpg

Concrete headwall on LS toe.

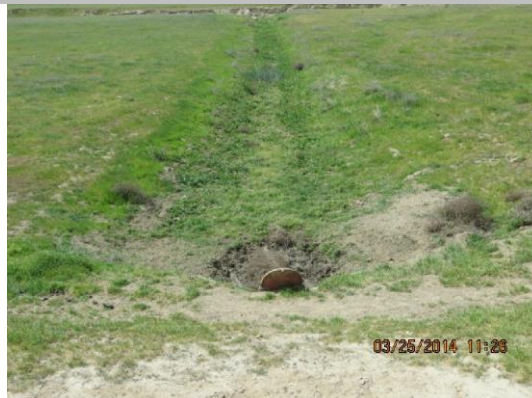
Photo 1 of 3 : UCIP\_SP\_2021\_62498\_59341.jpg

Comment Code						
Inspector Comment						
FS_ID:62498 DS_ID:19806 EP_NO: N/A Repair Type: Non-Urgent Crossing Status: Found UCIP Comments: 03/25/2014 Sediment buildup in pipe visible from landward side--recommend contacting owner to clear pipe. (W. Wylie - DWR UCIP) FIELD_STRUCT_DESC: 24-inch corrugated metal gravity drainage pipe through the levee, 10 feet below the crown. Flap gate on the waterside (WS) end. Concrete headwall on the landside (LS) end. Concrete U-shaped headwall on the WS end. [Additional Reference(s): DWR Levee Log, 2002 (HLM 26.10), listed as a 24-inch corrugated metal pipe (CMP). USACE San Joaquin O&M Manual, Unit 601 Part 1 (SJR601.1), 1967, Revised 25 May 2011, (HLM 26.11), listed as a 24-inch CMP] FS Date: 3/25/2014

Concrete headwall on WS toe.

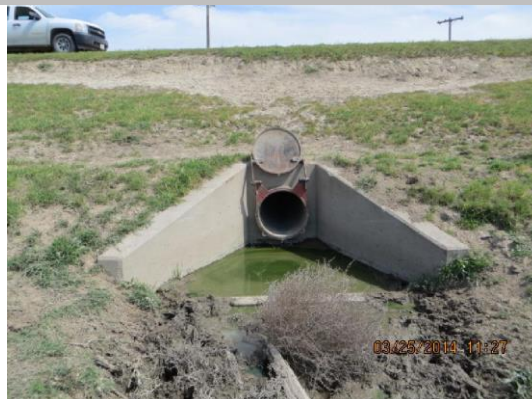
Photo 2 of 3 : UCIP\_SP\_2021\_62498\_59340.jpg

Flapgate on Concrete headwall at WS toe.

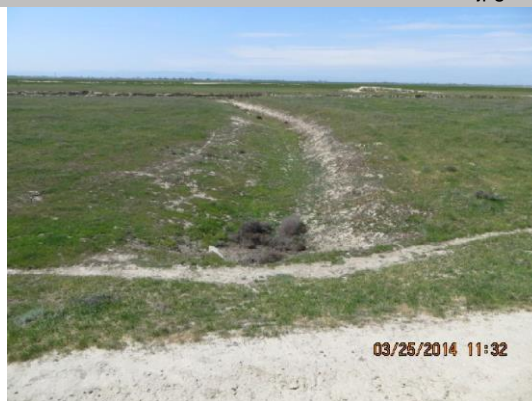
Photo 2 of 3 : UCIP\_SP\_2021\_62499\_59346.jpg

Concrete headwall on WS toe.

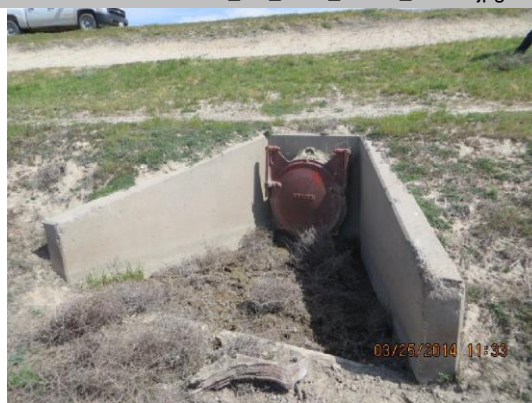
Photo 3 of 3 : UCIP\_SP\_2021\_62499\_59345.jpg

Flapgate on Concrete headwall at WS toe.

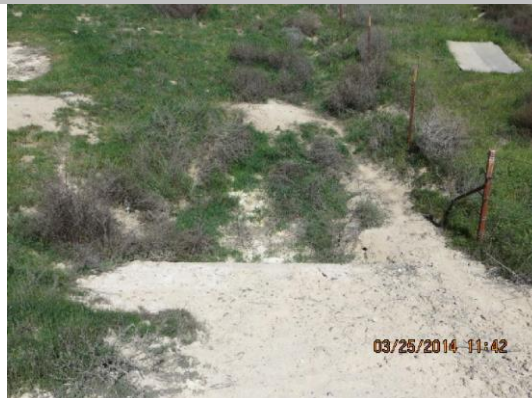
Photo 1 of 3 : UCIP\_SP\_2021\_62500\_59350.jpg

FS\_ID:62500  
DS\_ID:19808  
EP\_NO: N/A  
Repair Type: Non-Urgent  
Crossing Status: Found  
UCIP Comments: 03/25/2014 Pipe has heavy silt buildup visible from landward side--recommend contacting owner to clear pipe. (W. Wylie - DWR UCIP)  
FIELD\_STRUCT\_DESC: 24-inch corrugated metal gravity drainage pipe through the levee, 11.4 feet below the crown. Flap gate on the waterside (WS) end. Concrete headwall on the landside (LS) end. Concrete U-shaped headwall on the WS end. [Additional Reference(s): DWR Levee Log, 2002 (HLM 26.85), listed as a 24-inch corrugated metal pipe (CMP). USACE San Joaquin O&M Manual, Unit 601 Part 1 (SJR601.1), 1967, Revised 25 May 2011, (HLM 26.85), listed as a 24-inch CMP]  
FS Date: 3/25/2014

Concrete headwall on LS toe.

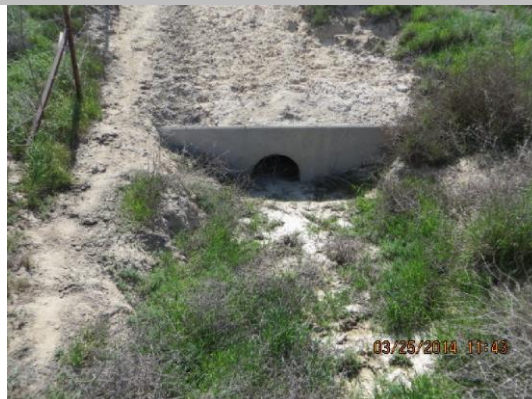
Photo 2 of 3 : UCIP\_SP\_2021\_62500\_59349.jpg

Concrete headwall on LS toe.

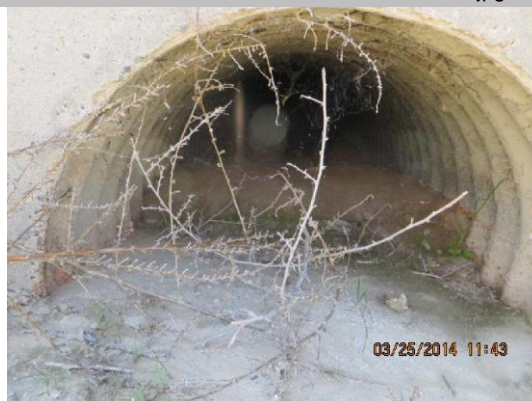
Photo 3 of 3 : UCIP\_SP\_2021\_62500\_59348.jpg

Silt buildup in pipe at LS toe.

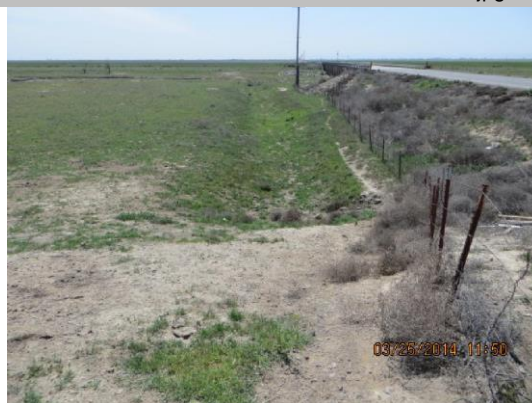
Photo 1 of 3 : UCIP\_SP\_2021\_62501\_59353.jpg

FS\_ID:62501  
 DS\_ID:19748  
 EP\_NO: N/A  
 Repair Type: Non-Urgent  
 Crossing Status: Found  
 UCIP Comments: 03/25/2014 Tumble weed buildup at inlet mat create blockage and should be removed. (W. Wylie - DWR UCIP)  
 FIELD\_STRUCT\_DESC: 24-inch corrugated metal gravity drainage pipe through the levee, 11.3 feet below the crown. Flap gate on the waterside (WS) end. Concrete headwall on the landside (LS) end. Concrete U-shaped headwall on the WS end. [Additional Reference(s): DWR Levee Log, 2002 (HLM 26.87), listed as a 24-inch corrugated metal pipe (CMP). USACE San Joaquin O&M Manual, Unit 601 Part 1 (SJR601.1), 1967, Revised 25 May 2011, (HLM 26.87), listed as a 24-inch CMP]  
 FS Date: 3/25/2014

Concrete headwall at WS toe.

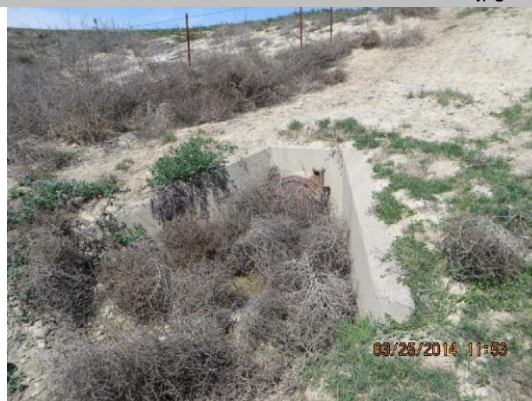
Photo 2 of 3 : UCIP\_SP\_2021\_62501\_59355.jpg

Flapgate and Concrete headwall at WS toe.

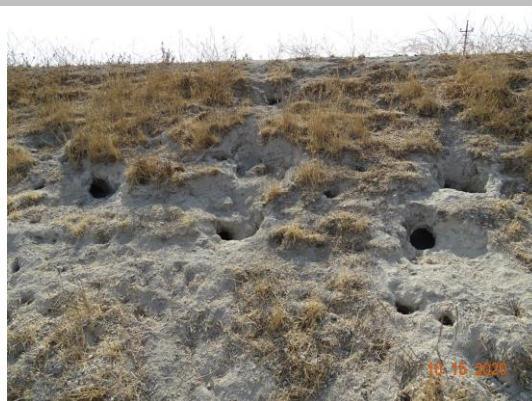
Photo 1 of 1 : SP\_2021\_NA0010\_123\_162\_20210308\_00045.jpg

LM Start	26.99	Rating **	U	Issue No.	162
LM End	27.04	Issue Type +	Ma	Location *	LS
Category	Earthen Levee			GPS Latitude/Longitude	
				Start	End
Item	Animal Control			37.032651 °	37.032659 °
				-120.473205 °	-120.472190 °
DWR ID	DWR_NA0010_05_f_2018_162				
Comment Code					
A1 : Exterminate rodents and backfill and compact or grout burrows.					
Inspector Comment					
Several rodent burrows with large quantities of material displaced noted in this section.

Several rodent burrows noted in this section of the levee. (Fall 2020)

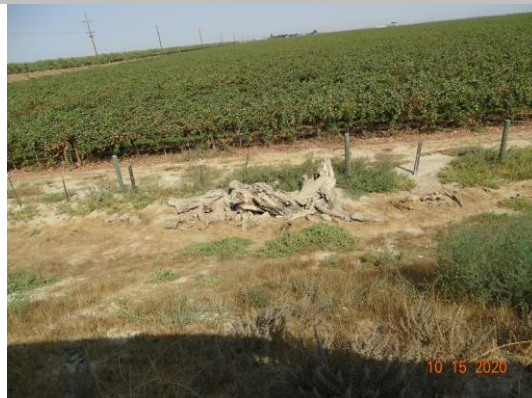
Photo 1 of 1 : SP\_2021\_NA0010\_123\_125\_20210308\_00021.jpg

LM Start	27.01	Rating **	M	Issue No.	125
LM End	27.01	Issue Type +	Ma	Location *	LS
Category	Earthen Levee			GPS Latitude/Longitude	
				Start	End
Item	Encroachments			37.032675 °	37.032675 °
				-120.472841 °	-120.472841 °
DWR ID	DWR_NA0010_05_s_2021_125				
Comment Code					
TR : Tree or limb					
Inspector Comment

Prunings left on the landside toe. (Fall 2020)

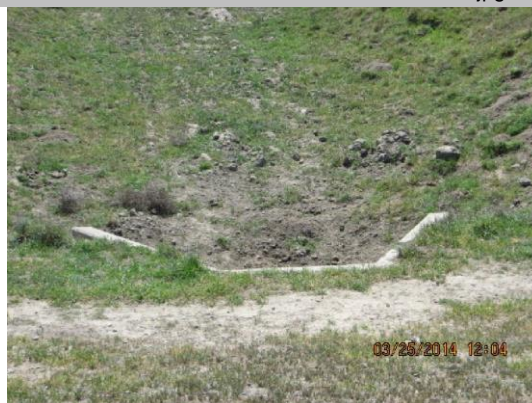
Photo 1 of 3 : UCIP\_SP\_2021\_62502\_59358.jpg

LM Start	27.31	Rating **	A/W	Issue No.	85	
LM End	27.31	Issue Type +	Ma	Location *		
Category	Supplemental			GPS Latitude/Longitude		
				Start		End
Item	DWR UCIP LMA Responsibility			37.032668 °		37.032668 °
				-120.467299 °		-120.467299 °
DWR ID	19749					
Comment Code						
Inspector Comment						
FS_ID:62502 DS_ID:19749 EP_NO: N/A Repair Type: No Action Needed Crossing Status: Found UCIP Comments: FIELD_STRUCT_DESC: 36-inch corrugated metal gravity drainage pipe through the levee, 12 feet below the crown. Flap gate on the waterside (WS) end. Concrete headwall on the landside (LS) end. Concrete U-shaped headwall on the WS end. [Additional Reference(s): DWR Levee Log, 2002 (HLM 27.21), listed as a 36-inch corrugated metal pipe (CMP). USACE San Joaquin O&M Manual, Unit 601 Part 1 (SJR601.1), 1967, Revised 25 May 2011, (HLM 27.22), listed as a 36-inch CMP] FS Date: 3/25/2014

Concrete headwall on WS toe.

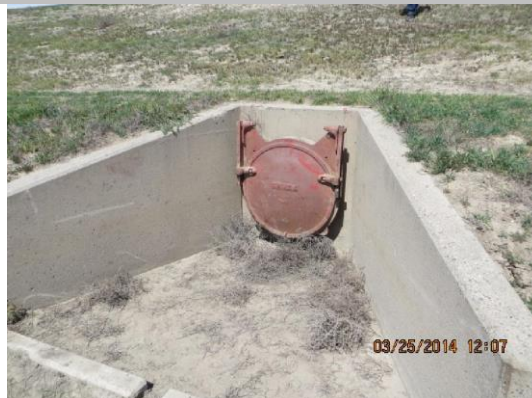
Photo 2 of 3 : UCIP\_SP\_2021\_62502\_59359.jpg

Flapgate at Concrete headwall on WS toe.

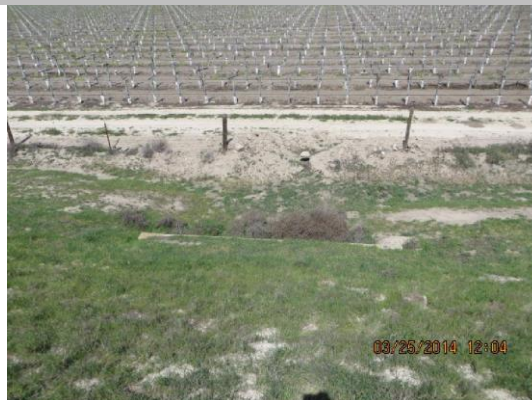
Photo 3 of 3 : UCIP\_SP\_2021\_62502\_59357.jpg

Concrete headwall on LS toe.

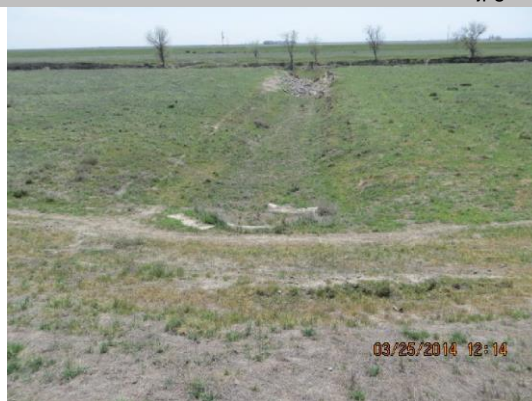
Photo 1 of 3 : UCIP\_SP\_2021\_62503\_59382.jpg

Comment Code						
Inspector Comment						
FS_ID:62503 DS_ID:19750 EP_NO: N/A Repair Type: Non-Urgent Crossing Status: Found UCIP Comments: 03/25/2014 Animal Burrowing activity at LS toe may undermine headwall. (W. Wylie - DWR UCIP) FIELD_STRUCT_DESC: 24-inch corrugated metal gravity drainage pipe through the levee, 10.8 feet below the crown. Flap gate on the waterside (WS) end. Concrete headwall on the landside (LS) end. Concrete U-shaped headwall on the WS end. [Additional Reference(s): DWR Levee Log, 2002 (HLM 28.17), listed as a 24-inch corrugated metal pipe (CMP). USACE San Joaquin O&M Manual, Unit 601 Part 1 (SJR601.1), 1967, Revised 25 May 2011, (HLM 28.17), listed as a 24-inch CMP] FS Date: 3/25/2014

Concrete headwall on WS toe.

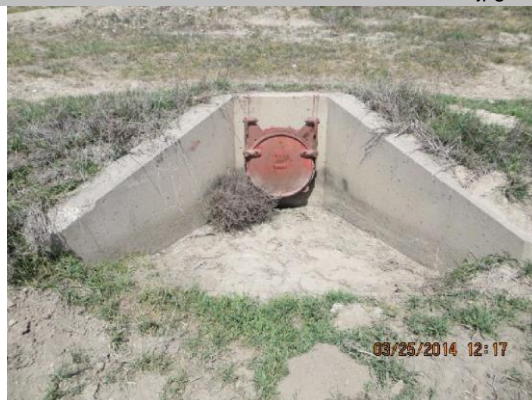
Photo 2 of 3 : UCIP\_SP\_2021\_62503\_59383.jpg

Flapgate on Concrete headwall at WS toe.

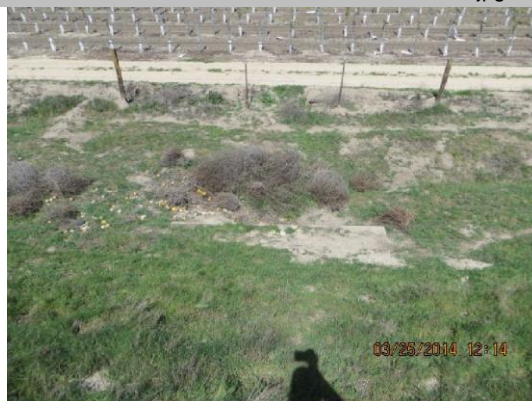
Photo 3 of 3 : UCIP\_SP\_2021\_62503\_59381.jpg

Concrete headwall on LS toe.

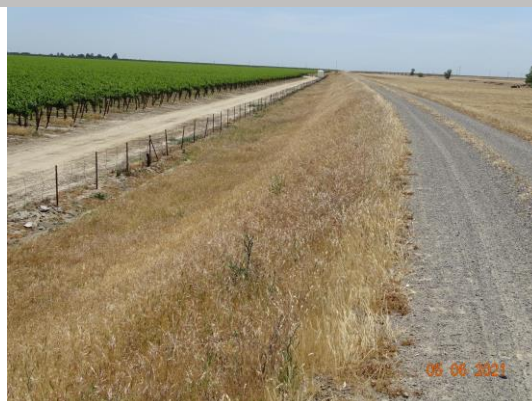
Photo 1 of 1 : SP\_2021\_NA0010\_123\_149\_20210517\_00326.jpg

LM Start	28.77	Rating **	M	Issue No.	149
LM End	30.55	Issue Type +	Ma	Location *	LS
Category	Earthen Levee			GPS Latitude/Longitude	
				Start	End
Item	Vegetation			37.031956 °	37.009507 °
				-120.441370 °	-120.425662 °
DWR ID	DWR_NA0010_05_s_2021_149				
Comment Code					
V1 : Control annual grass and weeds on the levee slopes and easements.					
Inspector Comment

View of vegetation on the landside slope and toe. (Spring 2021)

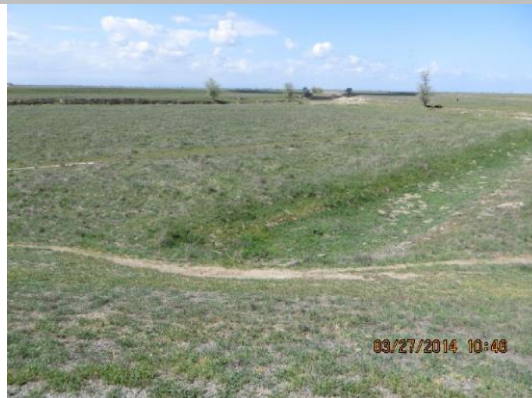
Photo 1 of 3 : UCIP\_SP\_2021\_62504\_59420.jpg

Concrete headwall on WS toe.

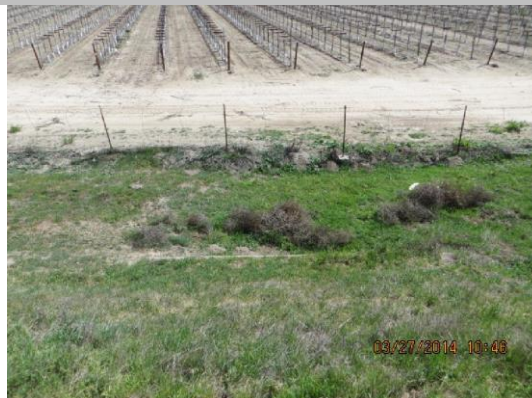
Photo 2 of 3 : UCIP\_SP\_2021\_62504\_59419.jpg

Concrete headwall on LS toe.

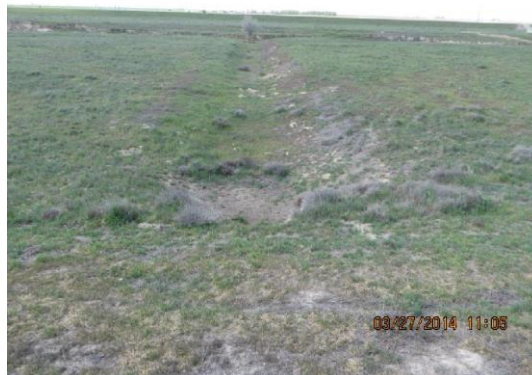
Photo 1 of 3 : UCIP\_SP\_2021\_62510\_59414.jpg

Comment Code						
Inspector Comment						
FS_ID:62510 DS_ID:19753 EP_NO: N/A Repair Type: Non-Urgent Crossing Status: Found UCIP Comments: 03/27/2014 Dense vegetation limits the inspector's visibility to identify signs of pipe failure (leaks) along the landward slope. Recommend removing vegetation along pipe alignment to conduct proper inspection of structure. Sediment buildup in pipe visible from landward side--recommend contacting owner to clear pipe. (W. Wylie - DWR UCIP) FIELD_STRUCT_DESC: 36-inch corrugated metal gravity drainage pipe through the levee, 10.2 feet below the crown. Flap gate on the waterside (WS) end. Concrete headwall on the landside (LS) end. Concrete U-shaped headwall on the WS end. [Additional Reference(s): DWR Levee Log, 2002 (HLM 29.49), listed as a 36-inch corrugated metal pipe (CMP). USACE San Joaquin O&M Manual, Unit 601 Part 1 (SJR601.1), 1967, Revised 25 May 2011, (HLM 29.49), listed as a 36-inch CMP] FS Date: 3/27/2014

Concrete headwall on WS toe.

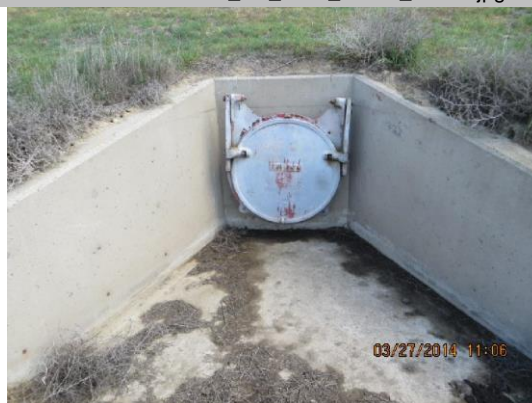
Photo 2 of 3 : UCIP\_SP\_2021\_62510\_59413.jpg

Flapgate on Concrete headwall at WS toe.

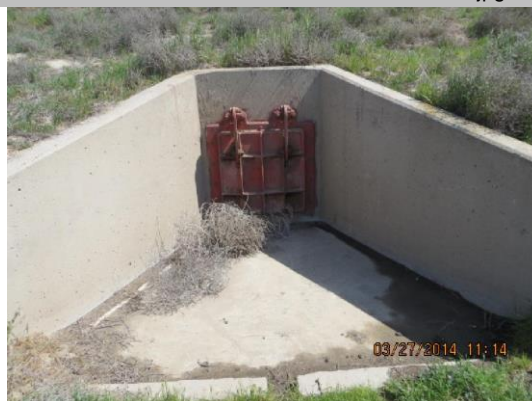
Photo 2 of 3 : UCIP\_SP\_2021\_62511\_59426.jpg

Flapgate on Concrete headwall at WS toe.

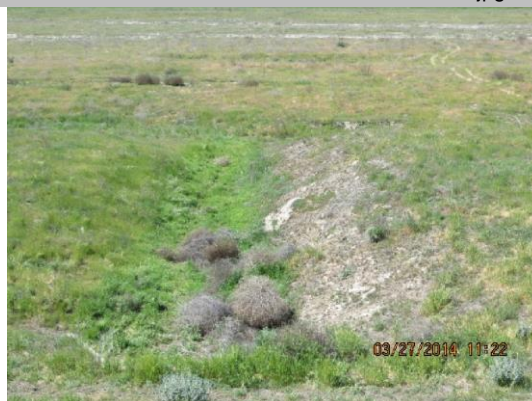
Photo 1 of 3 : UCIP\_SP\_2021\_62512\_59430.jpg

FS\_ID:62512  
DS\_ID:19696  
EP\_NO: N/A  
Repair Type: Non-Urgent  
Crossing Status: Found  
UCIP Comments: 03/27/2014 Dense vegetation limits the inspector's visibility to identify signs of pipe failure (leaks) along the landward slope. Recommend removing vegetation along pipe alignment to conduct proper inspection of structure. (W. Wylie - DWR UCIP)  
FIELD\_STRUCT\_DESC: 30-inch by 30-inch reinforced concrete box gravity drainage culvert through the levee, 13.1 feet below the crown. Flap gate on the waterside (WS) end. Concrete headwall on the landside (LS) end. Concrete U-shaped headwall on the WS end.  
[Additional Reference(s): DWR Levee Log, 2002 (HLM 30.04), listed as a 30-inch square reinforced concrete box culvert (RCBC). USACE San Joaquin O&M Manual, Unit 601 Part 1 (SJR601.1), 1967, Revised 25 May 2011, (HLM 30.04), listed as a 2.5-feet by 2.5-feet RCBC]  
FS Date: 3/27/2014

Concrete headwall on WS toe.

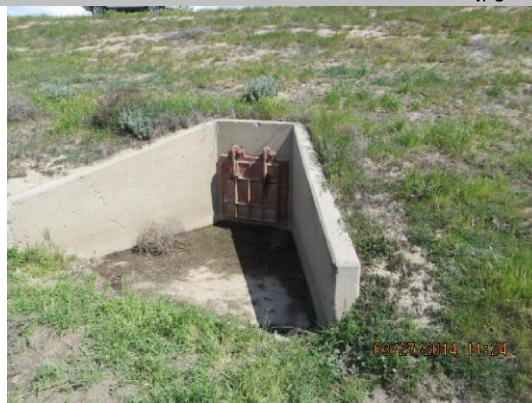
Photo 2 of 3 : UCIP\_SP\_2021\_62512\_59431.jpg

Flapgate on Concrete headwall at WS toe.

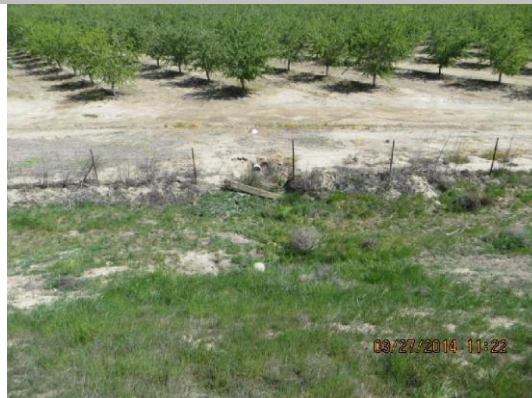
Photo 3 of 3 : UCIP\_SP\_2021\_62512\_59429.jpg

Concrete headwall on LS toe.

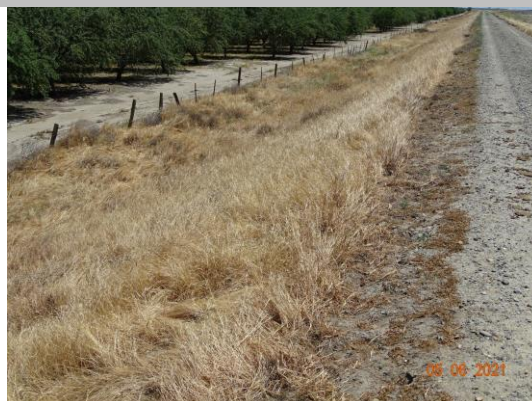
Photo 1 of 1 : SP\_2021\_NA0010\_123\_154\_20210517\_00328.jpg

LM Start	30.55	Rating **	U	Issue No.	154
LM End	31.28	Issue Type +	Ma	Location *	LS
Category	Earthen Levee			GPS Latitude/Longitude	
				Start	End
Item	Vegetation			37.009505 °	37.001889 °
				-120.425660 °	-120.416398 °
DWR ID	DWR_NA0010_05_s_2021_154				
Comment Code					
V1 : Control annual grass and weeds on the levee slopes and easements.					
Inspector Comment

Looking upstream along the landside slope. (Spring 2021)

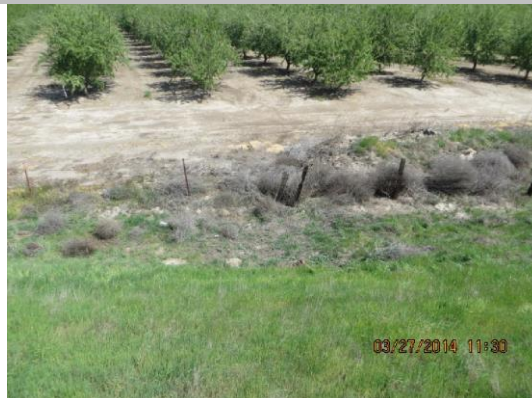
Photo 3 of 3 : UCIP\_SP\_2021\_62513\_59434.jpg

Concrete headwall on LS toe.

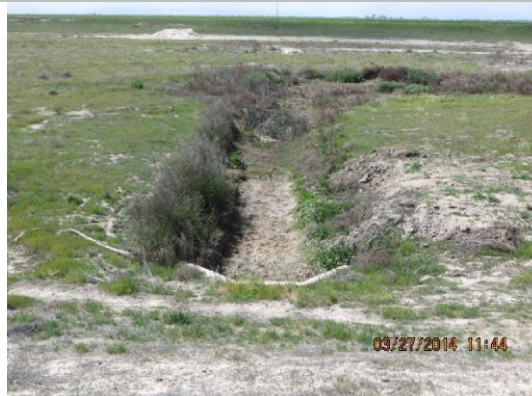
Photo 1 of 3 : UCIP\_SP\_2021\_62514\_59439.jpg

Comment Code						
Inspector Comment						
FS_ID:62514 DS_ID:19698 EP_NO: N/A Repair Type: Non-Urgent Crossing Status: Found UCIP Comments: 03/27/2014 Excess vegetation buildup at inlet on LS toe. Dense vegetation limits the inspector's visibility to identify signs of pipe failure (leaks) along the landward slope. Recommend removing vegetation along pipe alignment to conduct proper inspection of structure. (W. Wylie - DWR UCIP) FIELD_STRUCT_DESC: 30-inch by 30-inch reinforced concrete box gravity drainage culvert through the levee, 13.4 feet below the crown. Flap gate on the waterside (WS) end. Concrete headwall on the landside (LS) end. Concrete U-shaped headwall on the WS end. [Additional Reference(s): DWR Levee Log, 2002 (HLM 31.20), listed as a 30-inch square reinforced concrete box culvert (RCBC). USACE San Joaquin O&M Manual, Unit 601 Part 1 (SJR601.1), 1967, Revised 25 May 2011, (HLM 31.19), listed as a 2.5-feet by 2.5-feet RCBC] FS Date: 3/27/2014

Concrete headwall on WS toe.

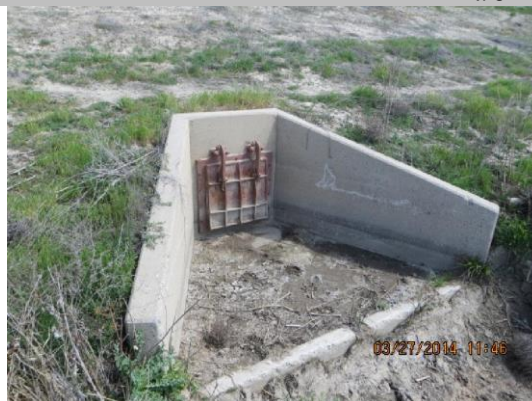
Photo 2 of 3 : UCIP\_SP\_2021\_62514\_59440.jpg

Flapgate at concrete headwall on WS toe.

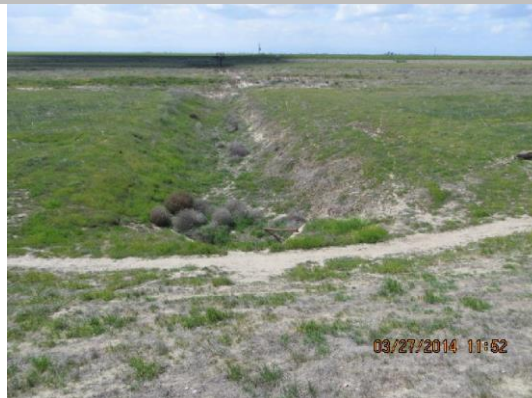
Photo 1 of 3 : UCIP\_SP\_2021\_62515\_59444.jpg

Concrete headwall on WS toe.

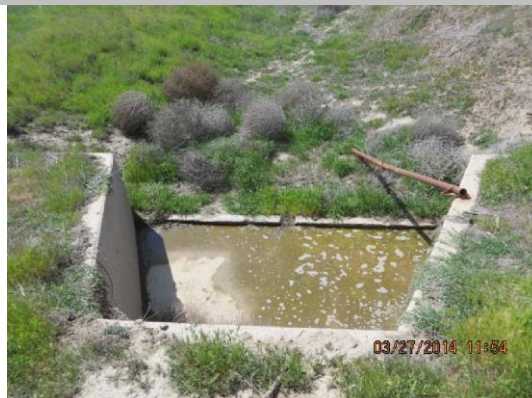
Photo 2 of 3 : UCIP\_SP\_2021\_62515\_59442.jpg

Concrete headwall on WS toe.

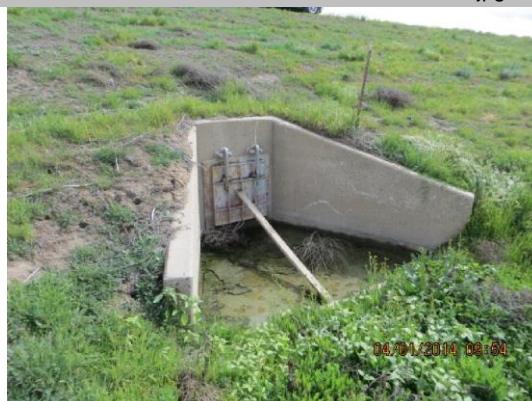
Photo 2 of 3 : UCIP\_SP\_2021\_62506\_59687.jpg

Flapgate on Concrete headwall at channel on WS toe.

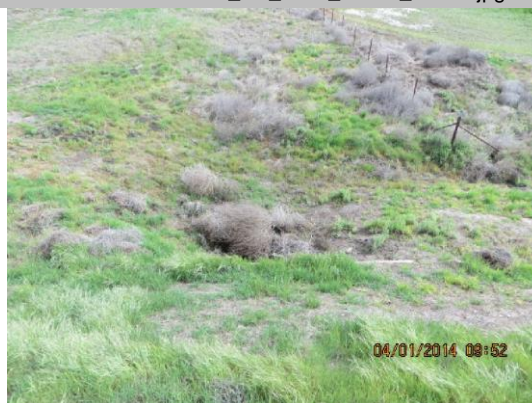
Photo 3 of 3 : UCIP\_SP\_2021\_62506\_59685.jpg

Concrete headwall on LS toe.

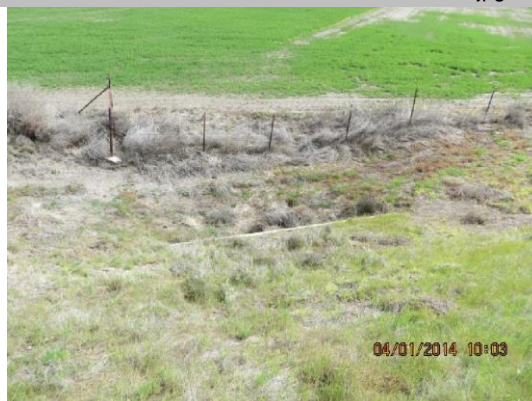
Photo 1 of 3 : UCIP\_SP\_2021\_62507\_59690.jpg

Comment Code						
Inspector Comment						
FS_ID:62507 DS_ID:19701 EP_NO: N/A Repair Type: Non-Urgent Crossing Status: Found UCIP Comments: 04/01/2014 Some silt buildup inside culvert. (W. Wylie - DWR UCIP) FIELD_STRUCT_DESC: 30-inch by 30-inch reinforced concrete box gravity drainage culvert through the levee, 14.2 feet below the crown. Flap gate on the waterside (WS) end. Concrete headwall on the landside (LS) end with flashboard attachment. Concrete U-shaped headwall on the WS end. [Additional Reference(s): DWR Levee Log, 2002 (HLM 32.22), listed as a 30-inch square reinforced concrete box culvert (RCBC). USACE San Joaquin O&M Manual, Unit 601 Part 1 (SJR601.1), 1967, Revised 25 May 2011, (HLM 32.22), listed as a 2.6-feet by 2.6-feet RCBC] FS Date: 4/1/2014

Concrete headwall at inlet on LS toe.

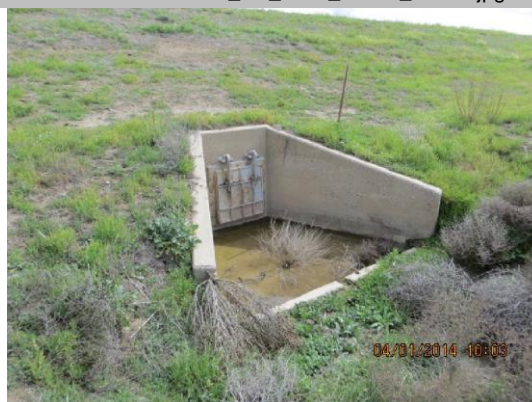
Photo 2 of 3 : UCIP\_SP\_2021\_62507\_59688.jpg

Flapgate on Concrete headwall at WS toe.

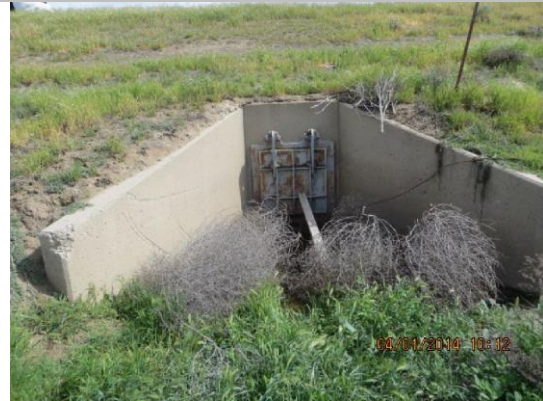
Photo 2 of 3 : UCIP\_SP\_2021\_62508\_59699.jpg

Flapgate on Concrete headwall at WS toe.

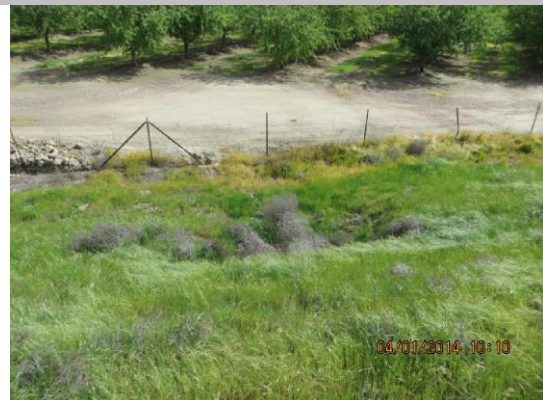
Photo 3 of 3 : UCIP\_SP\_2021\_62508\_59698.jpg

Concrete headwall at inlet on LS toe.

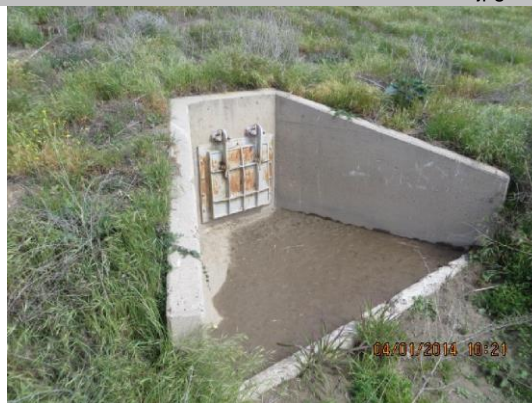
Photo 2 of 3 : UCIP\_SP\_2021\_62509\_59700.jpg

Flapgate on Concrete headwall at WS toe.

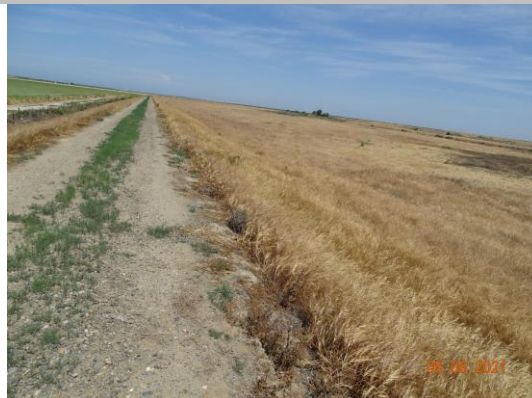
Photo 1 of 1 : SP\_2021\_NA0010\_123\_167\_20210517\_00330.jpg

LM Start	33.92	Rating **	U	Issue No.	167
LM End	34.84	Issue Type +	Ma	Location *	WS
Category	Earthen Levee			GPS Latitude/Longitude	
				Start	End
Item	Vegetation			36.977359 °	36.981430 °
				-120.380601 °	-120.367714 °
DWR ID	DWR_NA0010_05_s_2021_167				
Comment Code					
V1 : Control annual grass and weeds on the levee slopes and easements.					
Inspector Comment

Looking upstream at vegetation on the waterside slope. (Spring 2021)

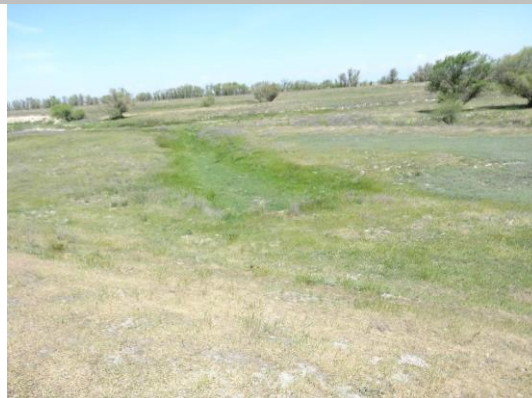
Photo 1 of 3 : UCIP\_SP\_2021\_62230\_66346.jpg

Comment Code						
Inspector Comment						
FS_ID:62230 DS_ID:19816 EP_NO: N/A Repair Type: Non-Urgent Crossing Status: Found UCIP Comments: 04/18/2014 Landward side blocked--need to contact owner to determine status of crossing. (O. Magana - DWR UCIP) FIELD_STRUCT_DESC: 24-inch corrugated metal gravity drainage pipe through the levee, 16.2 feet below the crown. Flap gate on the waterside (WS) end. Concrete U-shaped headwall on each end. [Additional Reference(s): DWR Levee Log, 2002 (HLM 0.86), listed as a 24-inch corrugated metal pipe (CMP). USACE San Joaquin O&M Manual, Unit 601 Part 1 (SRJ601.1), 1967, Revised 25 May 2011, (HLM 0.86), listed as a 24-inch CMP] FS Date: 4/18/2014

Overview of waterward side.

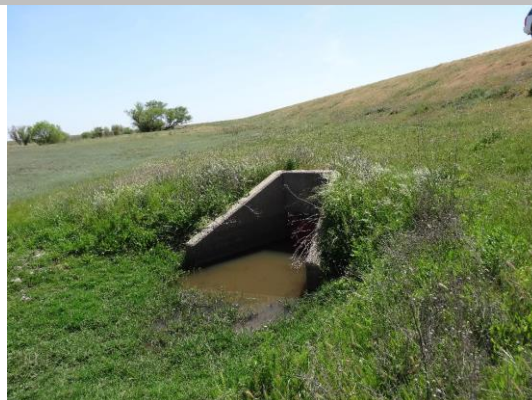
Photo 2 of 3 : UCIP\_SP\_2021\_62230\_66345.jpg

Concrete structure located on waterward toe.

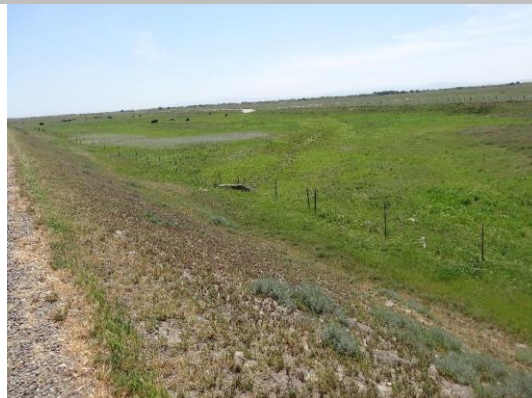
Photo 3 of 3 : UCIP\_SP\_2021\_62230\_66344.jpg

View of landward side.

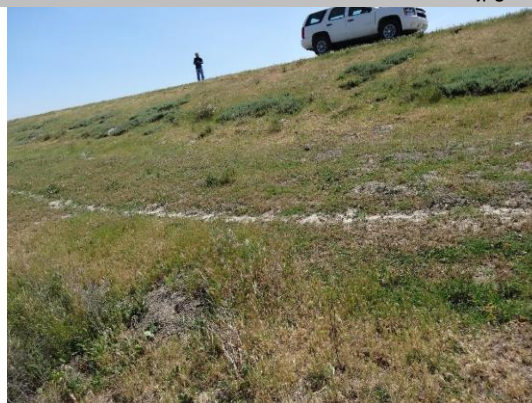
Photo 1 of 3 : UCIP\_SP\_2021\_62231\_66348.jpg

Comment Code						
Inspector Comment						
FS_ID:62231 DS_ID:19817 EP_NO: N/A Repair Type: Non-Urgent Crossing Status: Found UCIP Comments: 04/18/2014 No access was available to landward side due to fence. Recommend removing some of the vegetation on waterward toe. (O. Magana - DWR UCIP) FIELD_STRUCT_DESC: 24-inch corrugated metal gravity drainage pipe through the levee, 13.5 feet below the crown. Flap gate on the waterside (WS) end. Concrete headwall on each end. [Additional Reference(s): DWR Levee Log, 2002 (HLM 1.96), listed as a 24-inch corrugated metal pipe (CMP). USACE San Joaquin O&M Manual, Unit 601 Part 1 (SRJ601.1), 1967, Revised 25 May 2011, (HLM 1.95), listed as a 24-inch CMP] FS Date: 4/18/2014

View of waterward side.

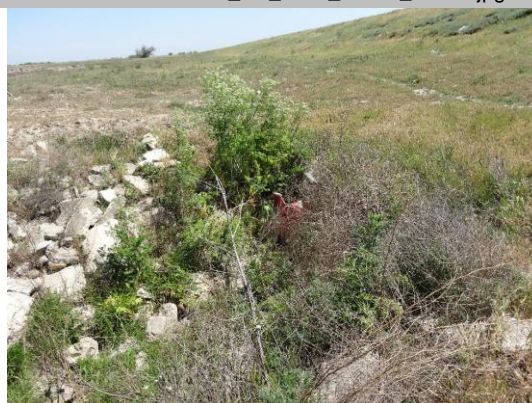
Photo 3 of 3 : UCIP\_SP\_2021\_62231\_66349.jpg

Flap gate visible on waterward side.

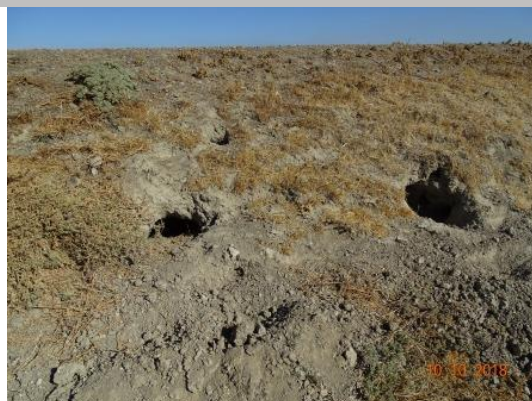
Photo 1 of 1 : SP\_2021\_NA0010\_124\_92\_20210308\_00022.jpg

LM Start	2.42	Rating **	U	Issue No.	92
LM End	2.42	Issue Type +	Ma	Location *	LS
Category	Earthen Levee			GPS Latitude/Longitude	
				Start	End
Item	Animal Control			37.254519 °	37.254519 °
				-120.795141 °	-120.795141 °
DWR ID	DWR_NA0010_06_f_2018_92				
Comment Code					
A3 : No rodents visible, but rodent burrows visible; need to backfill and compact or grout burrows.					
Inspector Comment

View of large rodent holes in landside slope. (Fall 2018)

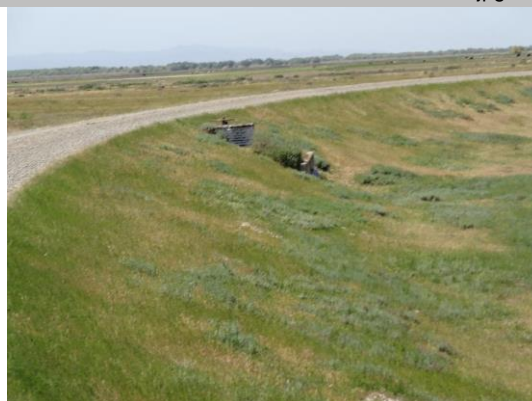
Photo 1 of 3 : UCIP\_SP\_2021\_62242\_66354.jpg

Comment Code						
Inspector Comment						
FS_ID:62242						
DS_ID:19818						
EP_NO: N/A						
Repair Type: Non-Urgent						
Crossing Status: Found						
UCIP Comments: 04/18/2014 Need to contact owner. Sediment buildup in pipe visible on landward side. (O. Magana - DWR UCIP)						
FIELD_STRUCT_DESC: 36-inch corrugated metal gravity drainage pipe through the levee, 6.9 feet below the crown. Slide gate in a 48-inch corrugated metal pipe (CMP) riser on the waterside (WS) slope. Concrete headwall on each end. [Additional Reference(s): DWR Levee Log, 2002 (HLM 2.61), listed as a 36-inch corrugated metal pipe (CMP). USACE San Joaquin O&M Manual, Unit 601 Part 1 (SRJ601.1), 1967, Revised 25 May 2011, (HLM 2.61), listed as a 36-inch CMP]						
FS Date: 4/18/2014

View of waterward side.

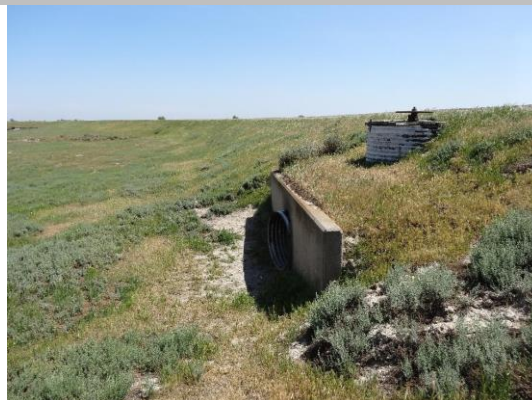
Photo 3 of 3 : UCIP\_SP\_2021\_62242\_66356.jpg

CMP riser, concrete headwall, and pipe visible on waterward side.

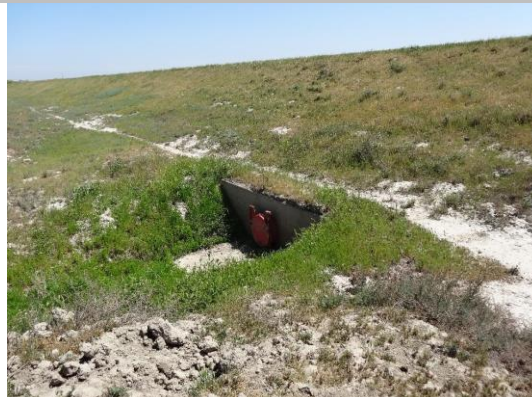
Photo 2 of 3 : UCIP\_SP\_2021\_62236\_66380.jpg

Comment Code						
Inspector Comment						
FS_ID:62236						
DS_ID:19821						
EP_NO: N/A						
Repair Type: Non-Urgent						
Crossing Status: Found						
UCIP Comments: 04/18/2014 Dense vegetation limits the inspector's visibility to identify signs of pipe condition on landward toe--headwall blocked by dense vegetation. Recommend removing vegetation from landward toe. (O. Magana - DWR UCIP)						
FIELD_STRUCT_DESC: 24-inch corrugated metal gravity drainage pipe through the levee, 11.2 feet below the crown. Flap gate on the waterside (WS) end. Concrete headwall on each end. [Additional Reference(s): DWR Levee Log, 2002 (HLM 3.09), listed as a 24-inch corrugated metal pipe (CMP). USACE San Joaquin O&M Manual, Unit 601 Part 1 (SRJ601.1), 1967, Revised 25 May 2011, (HLM 3.09), listed as a 24-inch CMP]						
FS Date: 4/18/2014

Flap gate and concrete headwall visible on waterward side.

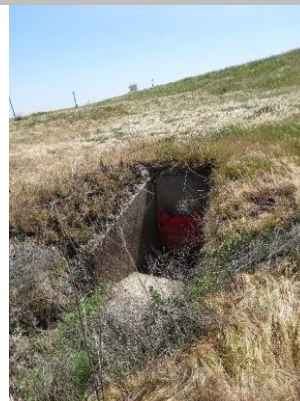
Photo 2 of 3 : UCIP\_SP\_2021\_62243\_66390.jpg

Flap gate and concrete headwall visible on waterward side.

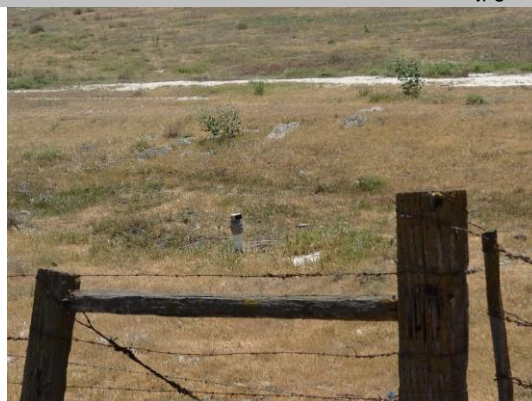
Photo 3 of 3 : UCIP\_SP\_2021\_62243\_66391.jpg

Comment Code					
Inspector Comment					
FS_ID:62243					
DS_ID:19823					
EP_NO: N/A					
Repair Type: Non-Urgent					
Crossing Status: Found					
UCIP Comments: 04/18/2014 Alignment of crossing unknown--altered crossing. No headwall found on landward side only siphon breaker found a short distance from landward toe. Tall grass observed on waterward slope and some burrow activity also noticed. Need to contact owner to determine alignment of crossing and status of crossing. (O. Magana - DWR UCIP)					
FIELD_STRUCT_DESC: 36-inch corrugated metal gravity drainage pipe through the levee, 15.7 feet below the crown. Flap gate on the waterside (WS) end. Concrete U-shaped headwall on each end. Bench mark (BM) stamped 9770-152 on top of the WS headwall. [Additional Reference(s): DWR Levee Log, 2002 (HLM 3.44), listed as a 36-inch corrugated metal pipe (CMP). USACE San Joaquin O&M Manual, Unit 601 Part 1 (SRJ601.1), 1967, Revised 25 May 2011, (HLM 3.43), listed as a 36-inch CMP]

View of landward side. No signs of concrete headwall only siphon breaker visible on landward side.

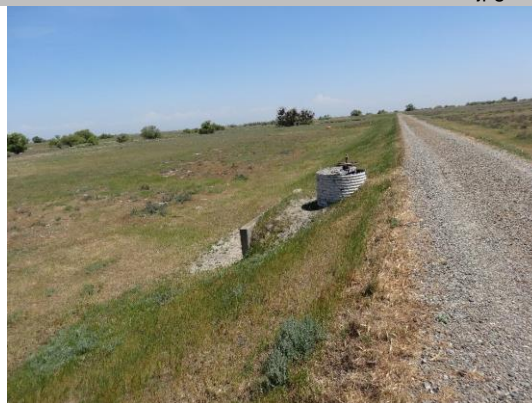
Photo 1 of 3 : UCIP\_SP\_2021\_62241\_66394.jpg

FS\_ID:62241  
 DS\_ID:19825  
 EP\_NO: N/A  
 Repair Type: Non-Urgent  
 Crossing Status: Found  
 UCIP Comments: 04/18/2014 Sediment buildup inside pipe visible from landward side. Excess soil is also present on landward toe partially blocking concrete headwall and inlet. Recommend removing soil from landward toe and clear buildup inside. (O. Magana - DWR UCIP)  
 FIELD\_STRUCT\_DESC: 36-inch corrugated metal gravity drainage pipe through the levee, 6.8 feet below the crown. Slide gate in a 48-inch corrugated metal pipe (CMP) riser on the waterside (WS) slope. Concrete headwall on each end. Pipe connects to a 30-inch steel drainage pipe on the WS. Drainage pipe extends to the pump on the WS on a support platform in the channel. (Extension drainage pipe and pump installed under Permit No. 12527, 1979 - Joseph Gallo).  
 [Additional Reference(s): DWR Levee Log, 2002 (HLM 3.54), listed as a 36-inch corrugated metal pipe (CMP). USACE San Joaquin O&M Manual, Unit 601 Part 1 (SRJ601.1), 1967, Revised 25 May 2011, (HLM 3.54), listed as a 36-inch CMP]

View of waterward side--cmp riser and concrete headwall visible.

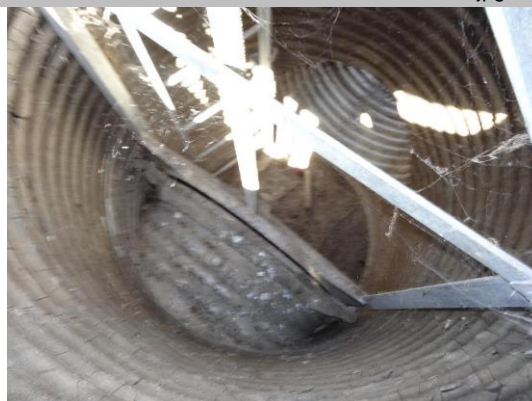
Photo 2 of 3 : UCIP\_SP\_2021\_62241\_66395.jpg

Inside view of cmp riser located on waterward slope.

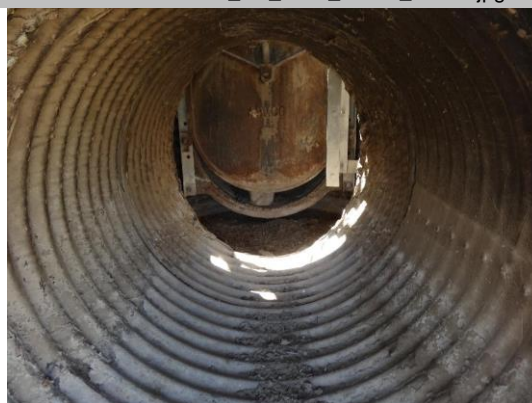
Photo 3 of 3 : UCIP\_SP\_2021\_62241\_66397.jpg

Inside view of pipe from waterward side.

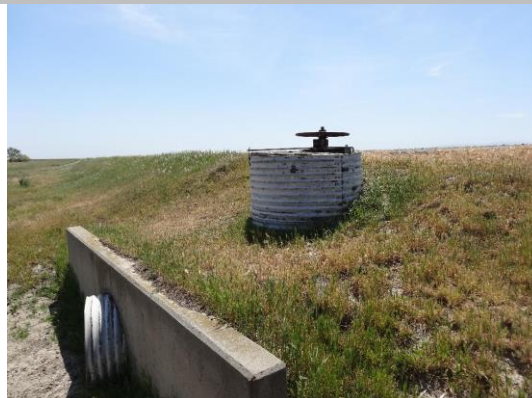
Photo 2 of 3 : UCIP\_SP\_2021\_62245\_66406.jpg

Slide gate inside CMP riser visible on waterward slope.

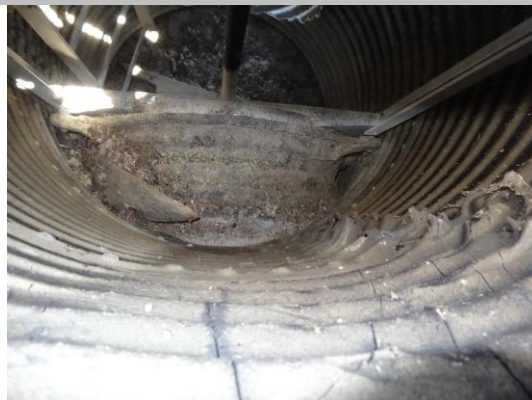
Photo 3 of 3 : UCIP\_SP\_2021\_62245\_66410.jpg

Inside view of CMP riser located on waterward side.

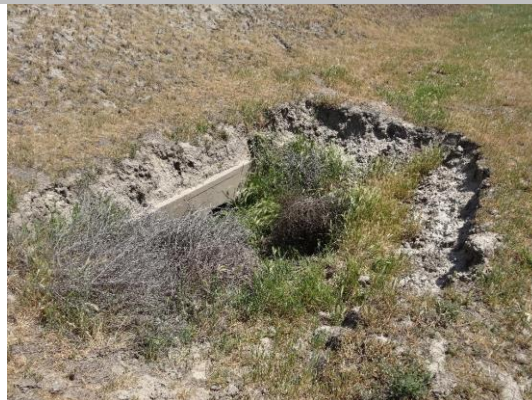
Photo 3 of 3 : UCIP\_SP\_2021\_62246\_66416.jpg

Concrete headwall visible on landward side.

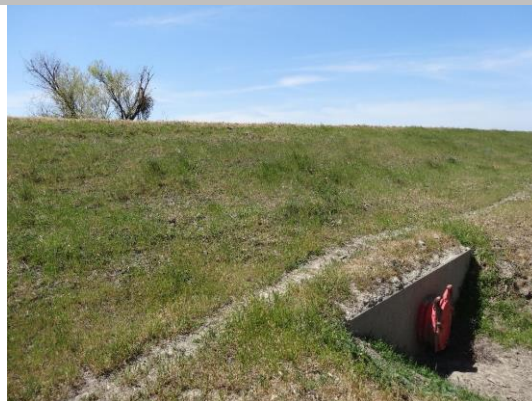
Photo 1 of 2 : UCIP\_SP\_2021\_62247\_66422.jpg

FS\_ID:62247  
DS\_ID:19829  
EP\_NO: N/A  
Repair Type: Non-Urgent  
Crossing Status: Found  
UCIP Comments: 04/18/2014 Dense vegetation limits the inspector's visibility to identify signs of pipe condition on landward toe--headwall blocked by dense vegetation. Recommend removing vegetation from landward toe. (O. Magana - DWR UCIP)  
FIELD\_STRUCT\_DESC: 24-inch corrugated metal gravity drainage pipe through the levee, 11.3 feet below the crown. Flap gate on the waterside (WS) end. Concrete headwall on each end. [Additional Reference(s): DWR Levee Log, 2002 (HLM 4.43), listed as a 24-inch corrugated metal pipe (CMP). USACE San Joaquin O&M Manual, Unit 601 Part 1 (SRJ601.1), 1967, Revised 25 May 2011, (HLM 4.41), listed as a 24-inch CMP]  
FS Date: 4/18/2014

View of waterward side--concrete headwall and flap gate visible.

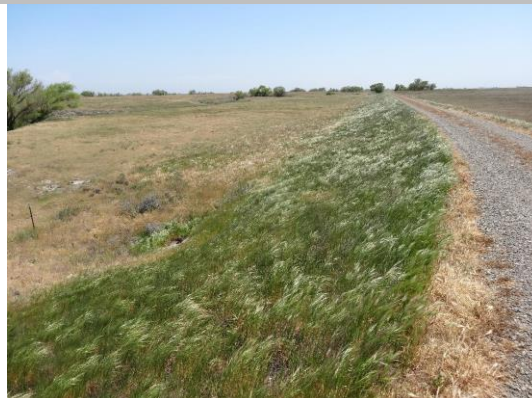
Photo 1 of 3 : UCIP\_SP\_2021\_62249\_66433.jpg

Comment Code						
Inspector Comment						
FS_ID:62249						
DS_ID:19831						
EP_NO: N/A						
Repair Type: Non-Urgent						
Crossing Status: Found						
UCIP Comments: 04/18/2014 Need to contact owner. Recommend removing tall grass on landward toe to determine condition of crossing from landward side. (O. Magana - DWR UCIP)						
FIELD_STRUCT_DESC: 24-inch corrugated metal gravity drainage pipe through the levee, 11.8 feet below the crown. Flap gate on the waterside (WS) end. Concrete headwall on each end. [Additional Reference(s): DWR Levee Log, 2002 (HLM 4.75), listed as a 24-inch corrugated metal pipe (CMP). USACE San Joaquin O&M Manual, Unit 601 Part 1 (SRJ601.1), 1967, Revised 25 May 2011, (HLM 4.75), listed as a 24-inch CMP]						
FS Date: 4/18/2014

View of waterward side.

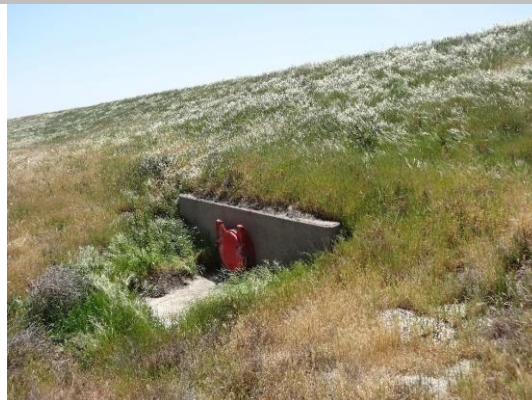
Photo 2 of 3 : UCIP\_SP\_2021\_62249\_66432.jpg

Flap gate, concrete headwall and apron visible on waterward toe.

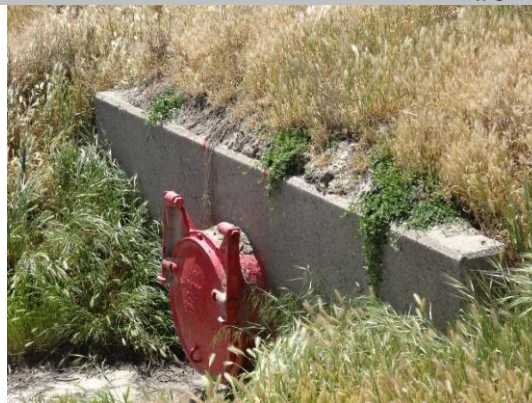
Photo 3 of 3 : UCIP\_SP\_2021\_62250\_66437.jpg

Close up of flap gate located on waterward side.

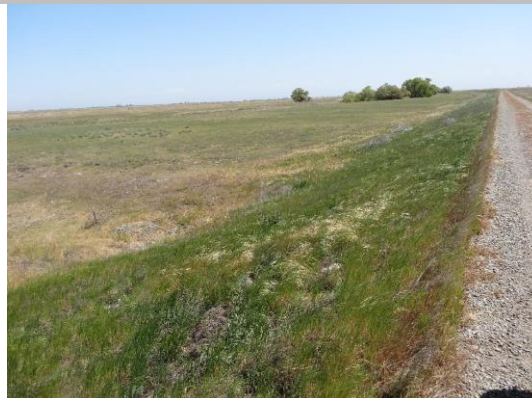
Photo 1 of 3 : UCIP\_SP\_2021\_62251\_61599.jpg

Comment Code						
Inspector Comment						
FS_ID:62251 DS_ID:19863 EP_NO: N/A Repair Type: Non-Urgent Crossing Status: Found UCIP Comments: 04/18/2014 Clear vegetation from waterward slope and landward headwall. (O. Magana - DWR UCIP) FIELD_STRUCT_DESC: 24-inch corrugated metal gravity drainage pipe through the levee, 10.9 feet below the crown. Flap gate on the waterside (WS) end. Concrete headwall on each end. [Additional Reference(s): DWR Levee Log, 2002 (HLM 5.35), listed as a 24-inch corrugated metal pipe (CMP). USACE San Joaquin O&M Manual, Unit 601 Part 1 (SRJ601.1), 1967, Revised 25 May 2011, (HLM 5.34), listed as a 24-inch CMP] FS Date: 4/18/2014

View of waterward side.

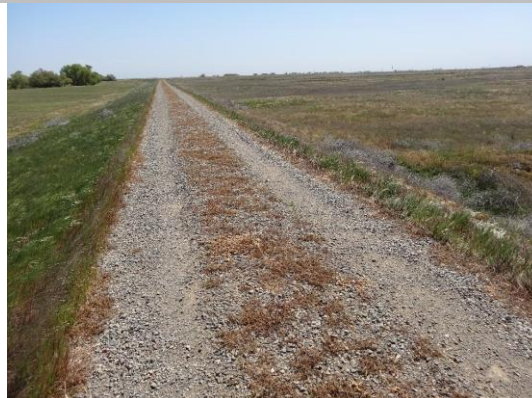
Photo 2 of 3 : UCIP\_SP\_2021\_62251\_61598.jpg

Overview of levee crown at crossing.

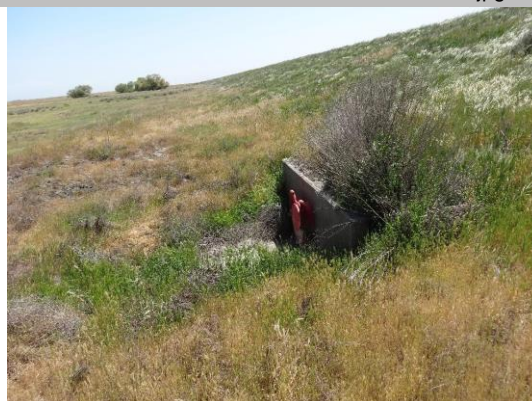
Photo 1 of 3 : UCIP\_SP\_2021\_62252\_66441.jpg

FS\_ID:62252  
 DS\_ID:19864  
 EP\_NO: N/A  
 Repair Type: Non-Urgent  
 Crossing Status: Found  
 UCIP Comments: 04/18/2014 Dense vegetation limits the inspector's visibility to identify signs of pipe failure (leaks) along the waterward slope. Recommend removing vegetation along pipe alignment to conduct proper inspection of structure. Also recommend removing excess vegetation at landward headwall. (O. Magana - DWR UCIP)  
 FIELD\_STRUCT\_DESC: 24-inch corrugated metal gravity drainage pipe through the levee, 11 feet below the crown. Flap gate on the waterside (WS) end. Concrete headwall on each end. [Additional Reference(s): DWR Levee Log, 2002 (HLM 5.63), listed as a 24-inch corrugated metal pipe (CMP). USACE San Joaquin O&M Manual, Unit 601 Part 1 (SRJ601.1), 1967, Revised 25 May 2011, (HLM 5.63), listed as a 24-inch CMP]  
 FS Date: 4/18/2014

Concrete headwall and flap gate visible on waterward toe.

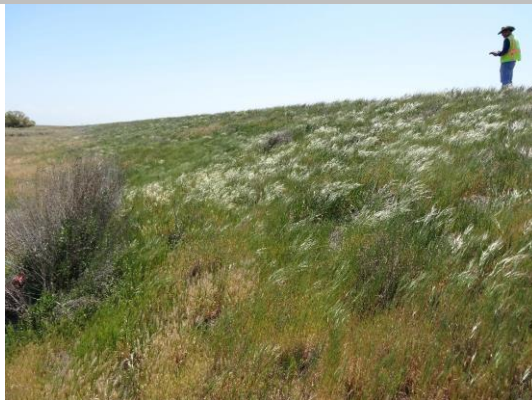
Photo 2 of 3 : UCIP\_SP\_2021\_62252\_66440.jpg

View of waterward side--dense vegetation covers slope.
