**Flood Control Project Maintenance  
Levee Inspections**

## Maintenance Issue Types Only, Levee Inspection Report By Mile - Spring 2021

### Lower San Joaquin Levee District

Waterway	Bank	Unit Miles	Inspection Start/End	Inspector
Unit No. 01 San Joaquin River	Right	22.52	05/04/2021 05/04/2021	Corey Fujitani

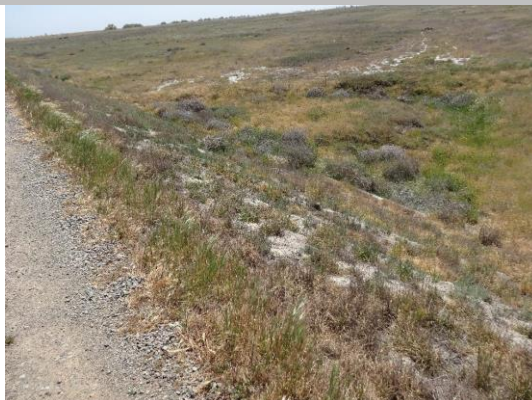
Photo 3 of 3 : UCIP\_SP\_2021\_62252\_66439.jpg

View of landward side.

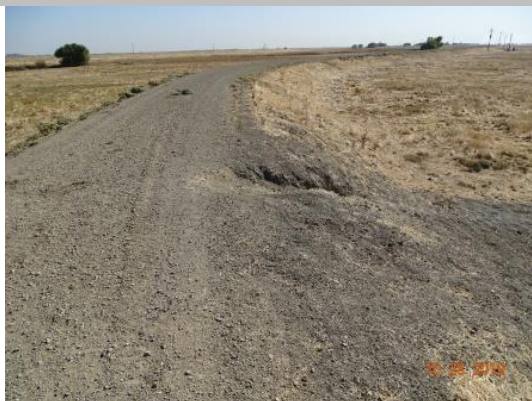
Photo 1 of 1 : SP\_2021\_NA0010\_124\_66\_20210308\_00006.jpg

LM Start	5.77	Rating **	M	Issue No.	66
LM End	5.77	Issue Type +	Ma	Location *	LS
Category	Earthen Levee			GPS Latitude/Longitude	
				Start	End
Item	Animal Control			37.238354 °	37.238354 °
				-120.742480 °	-120.742480 °
DWR ID	DWR_NA0010_06_f_2017_66				
Comment Code					
A2 : Repair the levee slope damaged by livestock and prevent large animal access.					
Inspector Comment					
There is damage to the landside slope and shoulder from livestock.

View of damage to landside slope from livestock traffic looking downstream. (Fall 2019)

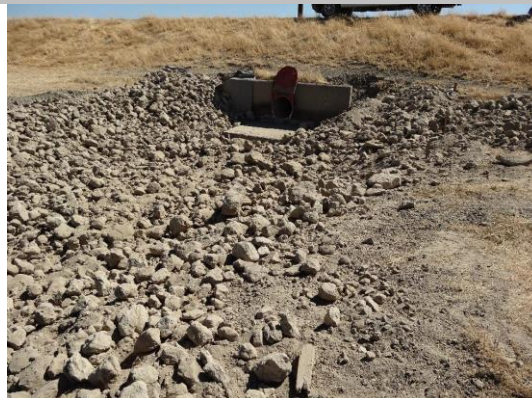
Photo 2 of 3 : UCIP\_SP\_2021\_62253\_75488.jpg

WS drainage path protected by rip rap.

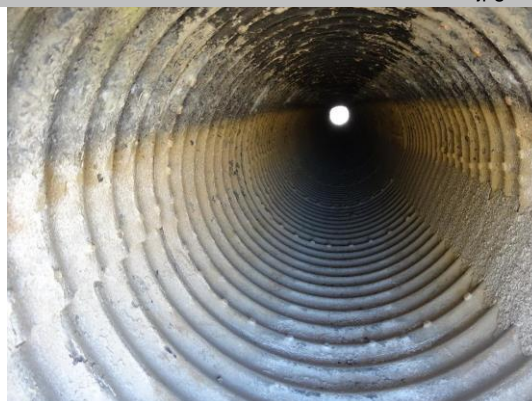
Photo 3 of 3 : UCIP\_SP\_2021\_62253\_75489.jpg

Inside view of pipe from WS.

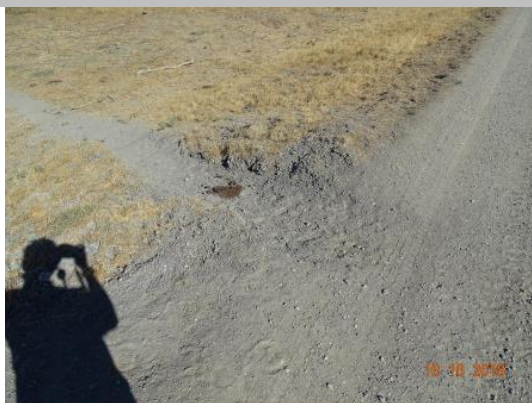
Photo 1 of 1 : SP\_2021\_NA0010\_124\_85\_20210308\_00018.jpg

LM Start	6.09	Rating **	M	Issue No.	85
LM End	6.09	Issue Type +	Ma	Location *	WS
Category	Earthen Levee			GPS Latitude/Longitude	
				Start	End
Item	Animal Control			37.235572 °	37.235572 °
				-120.738002 °	-120.738002 °
DWR ID	DWR_NA0010_06_f_2018_85				
Comment Code					
A2 : Repair the levee slope damaged by livestock and prevent large animal access.					
Inspector Comment					
Livestock damage to slope and shoulder of levee.

View of livestock damage on waterside slope. (Fall 2018)

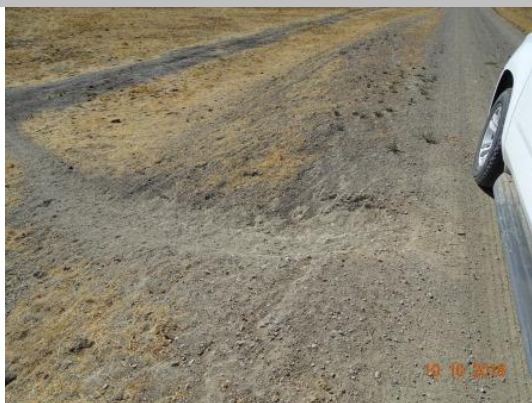
Photo 1 of 1 : SP\_2021\_NA0010\_124\_84\_20210308\_00017.jpg

LM Start	6.10	Rating **	M	Issue No.	84
LM End	6.10	Issue Type +	Ma	Location *	LS
Category	Earthen Levee			GPS Latitude/Longitude	
				Start	End
Item	Animal Control			37.235570 °	37.235570 °
				-120.737998 °	-120.737998 °
DWR ID	DWR_NA0010_06_f _ 2018_84				
Comment Code					
A2 : Repair the levee slope damaged by livestock and prevent large animal access.					
Inspector Comment					
Damage to slope and crown from livestock.

Erosion to slope and into crown from livestock. (Fall 2018)

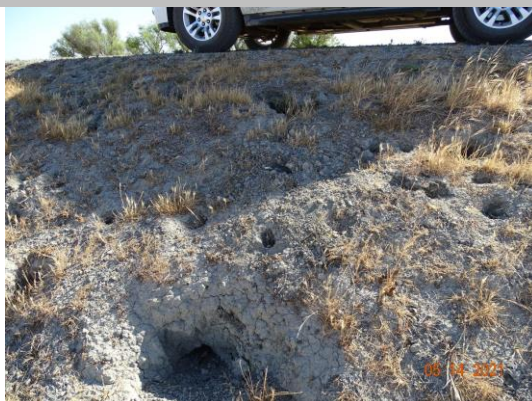
Photo 1 of 1 : SP\_2021\_NA0010\_124\_90\_20210517\_00172.jpg

LM Start	6.63	Rating **	M	Issue No.	90
LM End	6.63	Issue Type +	Ma	Location *	LS
Category	Earthen Levee			GPS Latitude/Longitude	
				Start	End
Item	Animal Control			37.231384 °	37.231384 °
				-120.730297 °	-120.730297 °
DWR ID	DWR_NA0010_06_s_2021_90				
Comment Code					
A3 : No rodents visible, but rodent burrows visible; need to backfill and compact or grout burrows.					
Inspector Comment

Looking at multiple rodent holes in the landside slope. (Spring 2021)

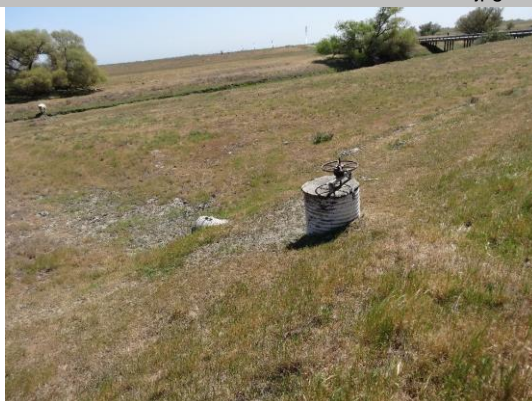
Photo 1 of 3 : UCIP\_SP\_2021\_62258\_61628.jpg

Comment Code					
Inspector Comment					
FS_ID:62258					
DS_ID:19866					
EP_NO: N/A					
Repair Type: No Action Needed					
Crossing Status: Found					
UCIP Comments:					
FIELD_STRUCT_DESC: 24-inch corrugated metal gravity drainage pipe through the levee, 7 feet below the crown. Slide gate in a 36-inch corrugated metal pipe (CMP) riser on the waterside (WS) slope. Concrete headwall on the landside (LS) end. Concrete saddle and apron on the WS end. [Additional Reference(s): DWR Levee Log, 2002 (HLM 6.78), listed as a 24-inch corrugated metal pipe (CMP). USACE San Joaquin O&M Manual, Unit 601 Part 1 (SRJ601.1), 1967, Revised 25 May 2011, (HLM 6.79), listed as a 24-inch CMP]					
FS Date: 4/18/2014

Slide gate inside CMP riser and pipe visible on waterward side.

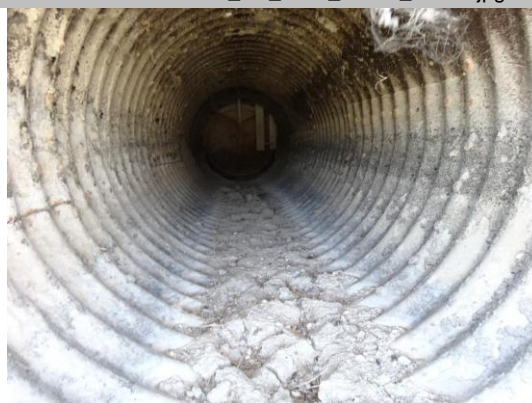
Photo 3 of 3 : UCIP\_SP\_2021\_62258\_61626.jpg

Inside view pipe from waterward side.

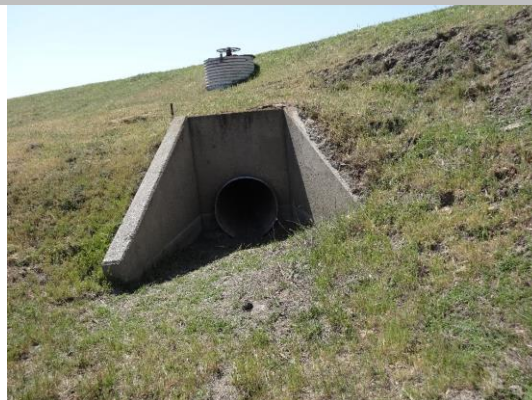
Photo 2 of 3 : UCIP\_SP\_2021\_62255\_61639.jpg

Concrete headwall and CMP riser visible on waterward side.

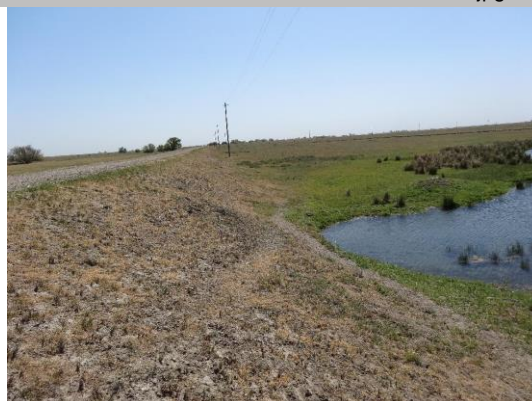
Photo 3 of 3 : UCIP\_SP\_2021\_62255\_61638.jpg

View of landward side.

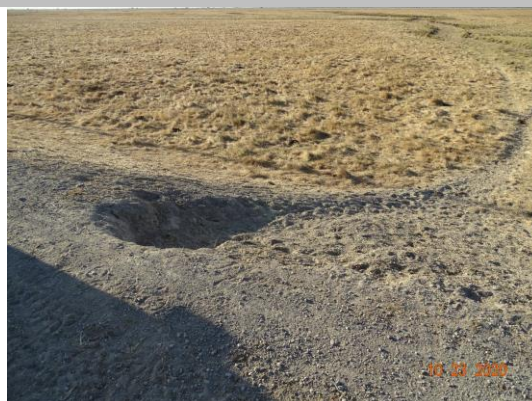
Photo 1 of 1 : SP\_2021\_NA0010\_124\_79\_20210308\_00013.jpg

LM Start	6.92	Rating **	A/W	Issue No.	79
LM End	6.92	Issue Type +	Ma	Location *	LS
Category	Earthen Levee			GPS Latitude/Longitude	
				Start	End
Item	Animal Control			37.228054 °	37.228054 °
				-120.727428 °	-120.727428 °
DWR ID	DWR_NA0010_06_f_2018_79				
Comment Code					
A2 : Repair the levee slope damaged by livestock and prevent large animal access.					
Inspector Comment					
Slope damage has been repaired with loose soil. Monitor for settlement.

View down the landside slope of damage from livestock. (Fall 2020)

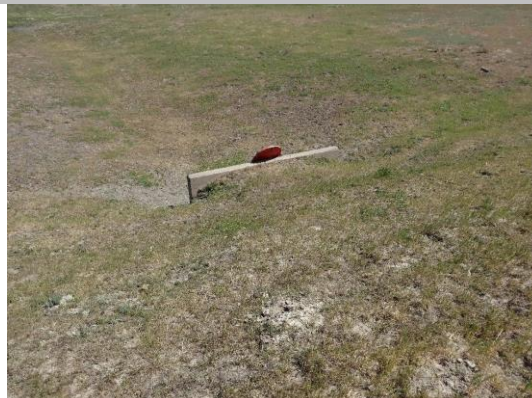
Photo 1 of 3 : UCIP\_SP\_2021\_62256\_61650.jpg

Comment Code					
Inspector Comment					
FS_ID:62256 DS_ID:19868 EP_NO: N/A Repair Type: Non-Urgent Crossing Status: Found UCIP Comments: 04/18/2014 Need to contact owner. Clear animal from waterward side. Some sediment buildup in pipe visible landward side--recommend clearing. (O. Magana - DWR UCIP) FIELD_STRUCT_DESC: 24-inch corrugated metal gravity drainage pipe through the levee, 10.6 feet below the crown. Flap gate on the waterside (WS) end. Concrete headwall on each end. [Additional Reference(s): DWR Levee Log, 2002 (HLM 7.29), listed as a 24-inch corrugated metal pipe (CMP). USACE San Joaquin O&M Manual, Unit 601 Part 1 (SRJ601.1), 1967, Revised 25 May 2011, (HLM 7.29), listed as a 24-inch CMP] FS Date: 4/18/2014

View of waterward side.

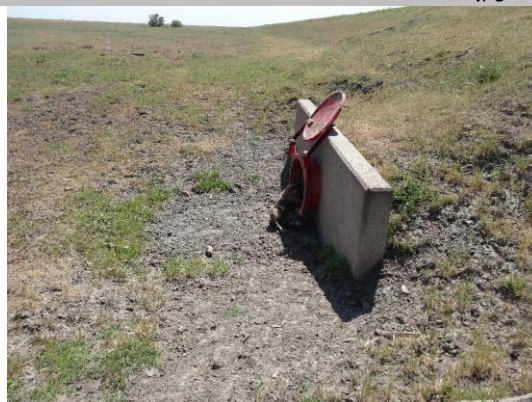
Photo 2 of 3 : UCIP\_SP\_2021\_62256\_61649.jpg

Concrete headwall and flap gate visible on waterward side. Dead animal inside pipe.

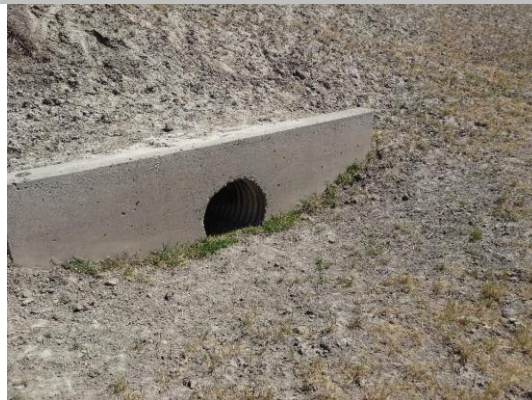
Photo 3 of 3 : UCIP\_SP\_2021\_62256\_61648.jpg

View of landward side.

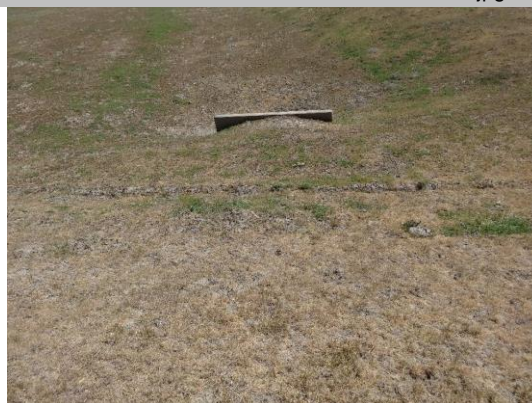
Photo 1 of 3 : UCIP\_SP\_2021\_62257\_66462.jpg

FS\_ID:62257  
 DS\_ID:19869  
 EP\_NO: N/A  
 Repair Type: Non-Urgent  
 Crossing Status: Found  
 UCIP Comments: 04/18/2014 Some sediment buildup in pipe visible on landward side--recommend clearing. (O. Magana - DWR UCIP)  
 FIELD\_STRUCT\_DESC: 24-inch corrugated metal gravity drainage pipe through the levee, 11.8 feet below the crown. Flap gate on the waterside (WS) end. Concrete headwall on each end. Skewed crossing.  
 [Additional Reference(s): DWR Levee Log, 2002 (HLM 7.74), listed as a 24-inch corrugated metal pipe (CMP). USACE San Joaquin O&M Manual, Unit 601 Part 1 (SRJ601.1), 1967, Revised 25 May 2011, (HLM 7.74), listed as a 24-inch CMP]  
 FS Date: 4/18/2014

View of waterward side.

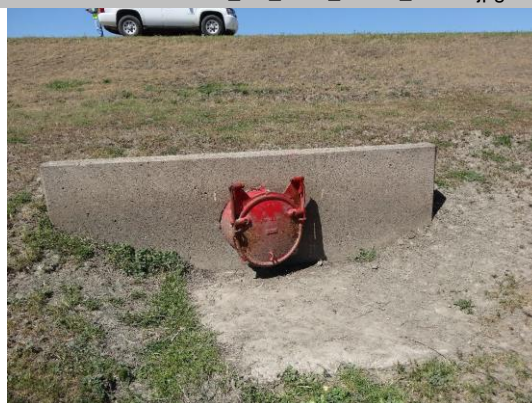
Photo 3 of 3 : UCIP\_SP\_2021\_62257\_66460.jpg

Concrete headwall and flap gate visible on waterward side.

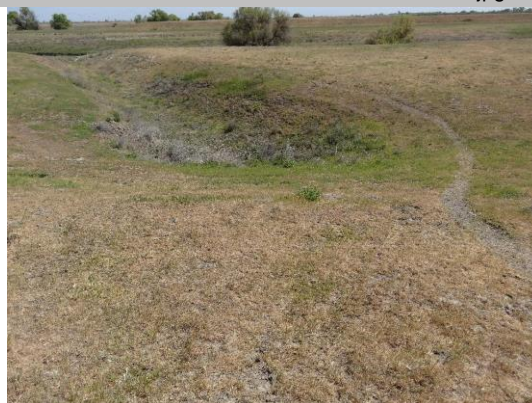
Photo 1 of 3 : UCIP\_SP\_2021\_62259\_61674.jpg

Comment Code						
Inspector Comment						
FS_ID:62259						
DS_ID:19870						
EP_NO: N/A						
Repair Type: Non-Urgent						
Crossing Status: Found						
UCIP Comments: 04/18/2014 Sediment buildup in pipe--recommend contacting owner to clear sediment. (O. Magana - DWR UCIP)						
FIELD_STRUCT_DESC: 24-inch corrugated metal gravity drainage pipe through the levee, 16.5 feet below the crown. Flap gate on the waterside (WS) end. Concrete headwall on each end. [Additional Reference(s): DWR Levee Log, 2002 (HLM 8.22), listed as a 24-inch corrugated metal pipe (CMP). USACE San Joaquin O&M Manual, Unit 601 Part 1 (SRJ601.1), 1967, Revised 25 May 2011, (HLM 8.21), listed as a 24-inch CMP]						
FS Date: 4/18/2014

View of waterward side.

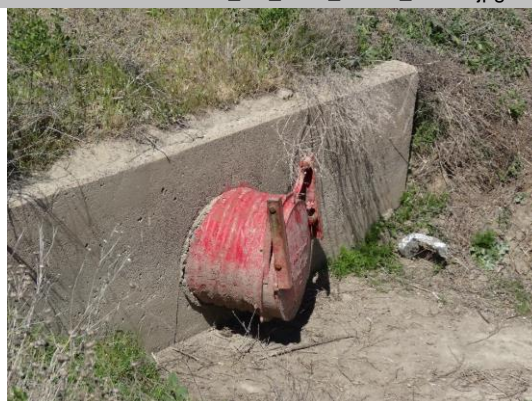
Photo 3 of 3 : UCIP\_SP\_2021\_62259\_61672.jpg

Concrete headwall and flap gate visible on waterward side.

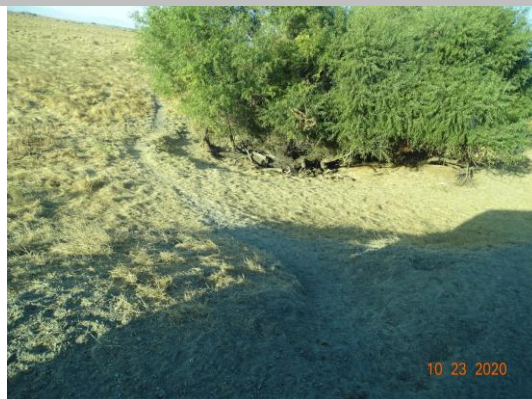
Photo 1 of 1 : SP\_2021\_NA0010\_124\_104\_20210308\_00029.jpg

LM Start	8.20	Rating **	A/W	Issue No.	104
LM End	8.20	Issue Type +	Ma	Location *	LS
Category	Earthen Levee			GPS Latitude/Longitude	
				Start	End
Item	Animal Control			37.215588 °	37.215588 °
				-120.712406 °	-120.712406 °
DWR ID	DWR_NA0010_06_f_2020_104				
Comment Code					
A2 : Repair the levee slope damaged by livestock and prevent large animal access.					
Inspector Comment					
Slope damage has been repaired with loose soil. Monitor for settlement.

Livestock damage to the landside slope. (Fall 2020)

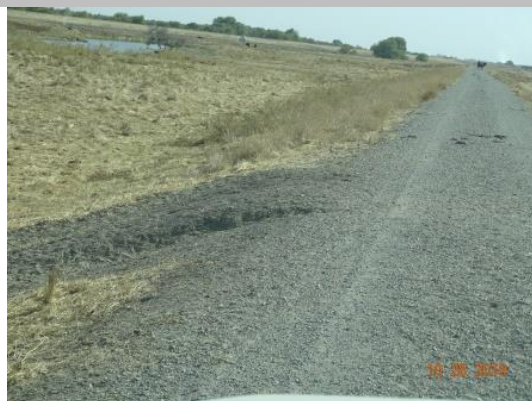
Photo 1 of 1 : SP\_2021\_NA0010\_124\_89\_20210308\_00020.jpg

LM Start	8.32	Rating **	A/W	Issue No.	89
LM End	8.32	Issue Type +	Ma	Location *	WS
Category	Earthen Levee			GPS Latitude/Longitude	
				Start	End
Item	Animal Control			37.214273 °	37.214273 °
				-120.711100 °	-120.711100 °
DWR ID	DWR_NA0010_06_f_2019_89				
Comment Code					
A2 : Repair the levee slope damaged by livestock and prevent large animal access.					
Inspector Comment					
Slope damage has been repaired with loose soil. Monitor for settlement.

View of damage to the waterside slope looking upstream. (Fall 2019)

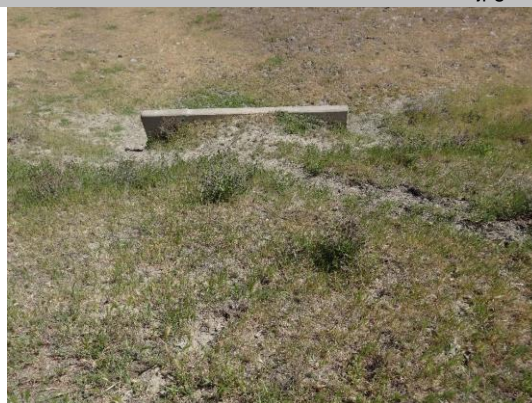
Photo 1 of 3 : UCIP\_SP\_2021\_62260\_61685.jpg

Comment Code					
Inspector Comment					
FS_ID:62260 DS_ID:19871 EP_NO: N/A Repair Type: Non-Urgent Crossing Status: Found UCIP Comments: 04/18/2014 Need to contact owner. Sediment buildup in pipe visible on landward side--recommend clearing. Good candidate for pressure test or video inspection due to signs of heavy corrosion. If no leaks after tests this crossing would be a good candidate for rehabilitation. (O. Magana - DWR UCIP) FIELD_STRUCT_DESC: 24-inch corrugated metal gravity drainage pipe through the levee, 9.2 feet below the crown. Flap gate on the waterside (WS) end. Concrete headwall on each end. [Additional Reference(s): DWR Levee Log, 2002 (HLM 8.51), listed as a 24-inch corrugated metal pipe (CMP). USACE San Joaquin O&M Manual, Unit 601 Part 1 (SRJ601.1), 1967, Revised 25 May 2011, (HLM 8.51), listed as a 24-inch CMP] FS Date: 4/18/2014

View of waterward side.

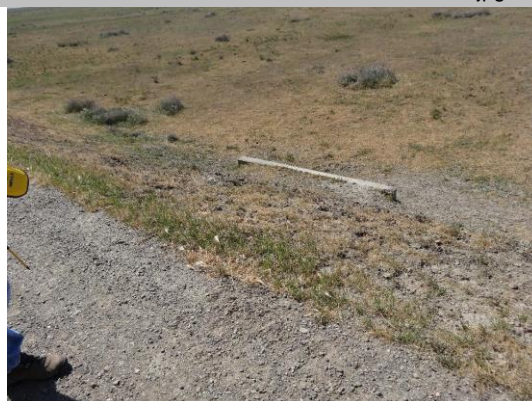
Photo 2 of 3 : UCIP\_SP\_2021\_62260\_61684.jpg

View of landward side.

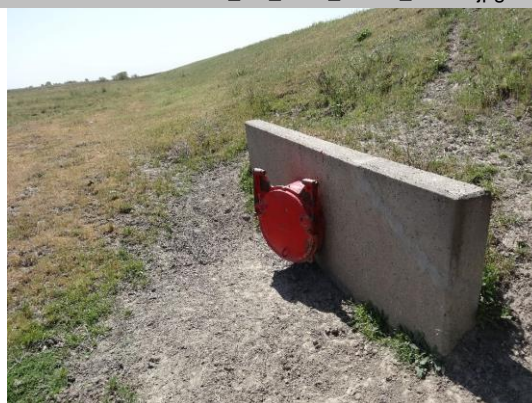
Photo 3 of 3 : UCIP\_SP\_2021\_62260\_61683.jpg

Pipe crosses levee at an angle.

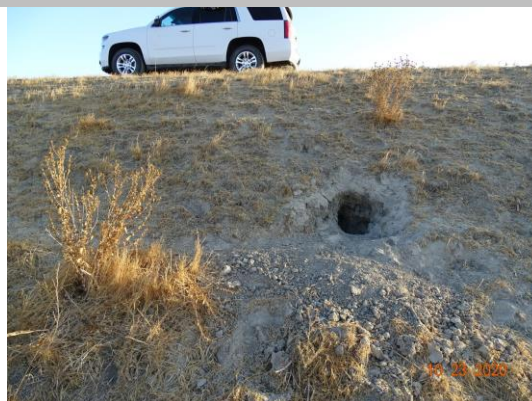
Photo 1 of 1 : SP\_2021\_NA0010\_124\_102\_20210308\_00027.jpg

LM Start	10.12	Rating **	U	Issue No.	102
LM End	10.12	Issue Type +	Ma	Location *	LS
Category	Earthen Levee			GPS Latitude/Longitude	
				Start	End
Item	Animal Control			37.196845 °	37.196845 °
				-120.687892 °	-120.687892 °
DWR ID	DWR_NA0010_06_f_2020_102				
Comment Code					
A3 : No rodents visible, but rodent burrows visible; need to backfill and compact or grout burrows.					
Inspector Comment

View of large animal burrow in the landside slope. (Fall 2020)

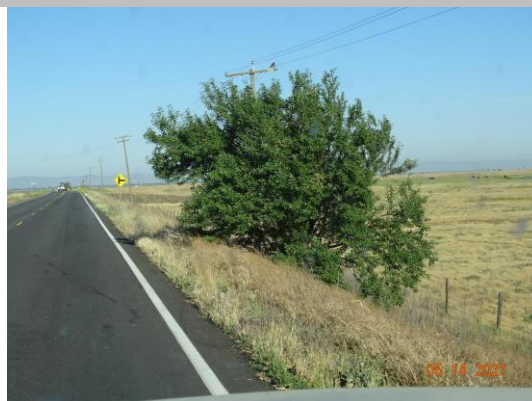
Photo 1 of 1 : SP\_2021\_NA0010\_124\_14\_20210517\_00173.jpg

LM Start	11.49	Rating **	M	Issue No.	14
LM End	11.49	Issue Type +	Ma	Location *	WS
Category	Earthen Levee			GPS Latitude/Longitude	
				Start	End
Item	Trim / Thin Trees			37.186189 °	37.186189 °
				-120.668476 °	-120.668476 °
DWR ID	DWR_NA0010_06_s_2015_14				
Comment Code					
T1 : Trim trees to at least five feet above ground level.					
Inspector Comment					
Almond tree located along Sandy Mush Road on waterside slope.

Looking west at tree on waterward slope. (Spring 2021)

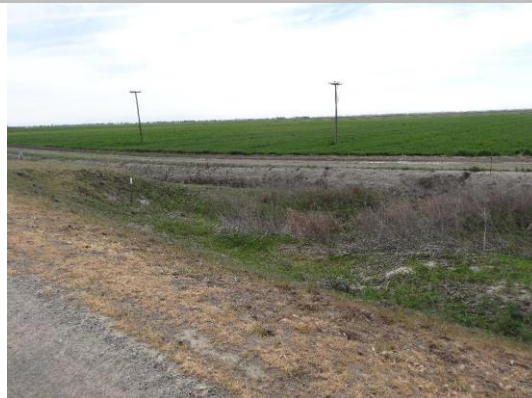
Photo 2 of 3 : UCIP\_SP\_2021\_62268\_66487.jpg

Comment Code						
Inspector Comment						
FS_ID:62268 DS_ID:19876 EP_NO: N/A Repair Type: Non-Urgent Crossing Status: Found UCIP Comments: 04/17/2014 Clear debris from waterward and landward toes. (O. Magana - DWR UCIP) FIELD_STRUCT_DESC: 36-inch corrugated metal gravity drainage pipe through the levee, 17 feet below the crown. Slide gate in a pipe riser on the waterside (WS) slope. [Additional Reference(s): DWR Levee Log, 2002 (HLM 11.83), listed as a 36-inch corrugated metal pipe (CMP). USACE San Joaquin O&M Manual, Unit 601 Part 1 (SJR601.1), 1967, Revised 25 May 2011, (HLM 11.82), listed as a 36-inch CMP]. FS Date: 4/17/2014

View of landward side.

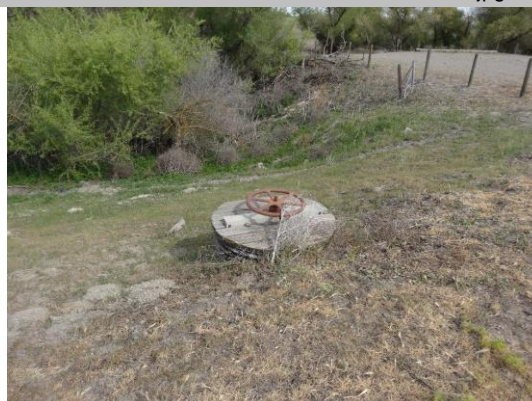
Photo 3 of 3 : UCIP\_SP\_2021\_62268\_66486.jpg

Slide gate inside CMP riser located on waterward slope.

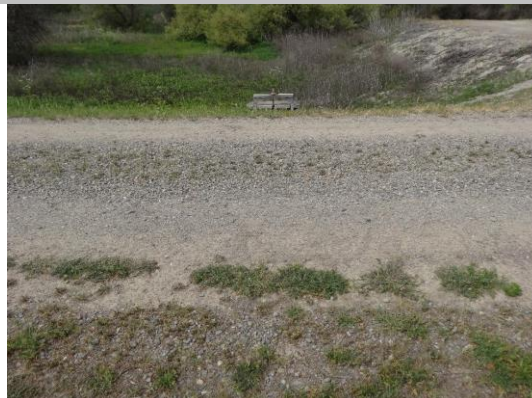
Photo 1 of 3 : UCIP\_SP\_2021\_62270\_66492.jpg

Comment Code					
Inspector Comment					
FS_ID:62270 DS_ID:19877 EP_NO: N/A Repair Type: Non-Urgent Crossing Status: Found UCIP Comments: 04/17/2014 Not accessible--crossing is buried on landward side. Need to contact owner to determine status. (O. Magana - DWR UCIP) FIELD_STRUCT_DESC: 24-inch corrugated metal gravity drainage pipe through the levee, 10.8 feet below the crown. Flap gate on the waterside (WS) end. [Additional Reference(s): DWR Levee Log, 2002 (HLM 18.91), listed as a 24-inch corrugated metal pipe (CMP). USACE San Joaquin O&M Manual, Unit 601 Part 1 (SJR601.1), 1967, Revised 25 May 2011, (HLM 13.30), listed as a 24-inch CMP]. FS Date: 4/17/2014

View of levee crown at crossing.

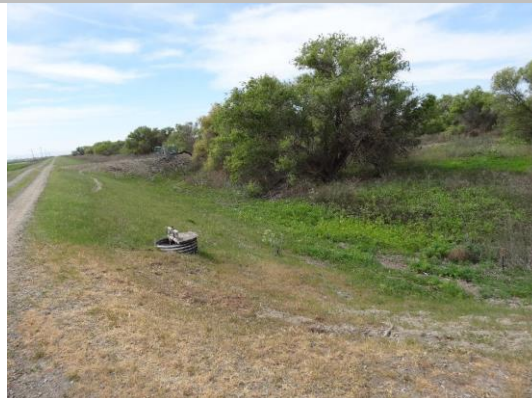
Photo 2 of 3 : UCIP\_SP\_2021\_62270\_66494.jpg

View of waterward slope.

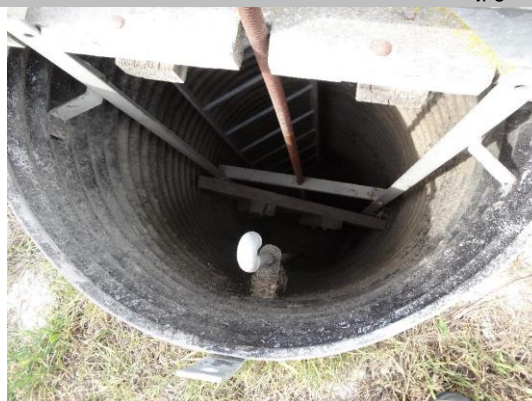
Photo 3 of 3 : UCIP\_SP\_2021\_62270\_66495.jpg

Inside view of CMP riser located on waterward slope.

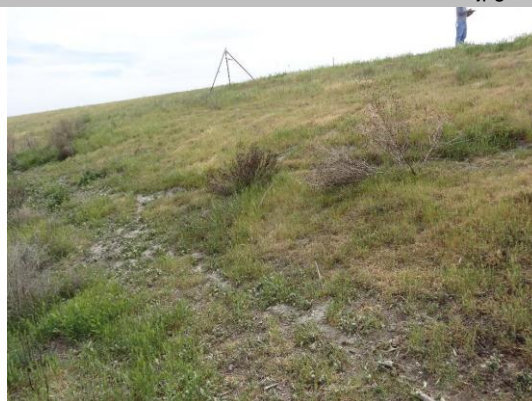
Photo 1 of 3 : UCIP\_SP\_2021\_62271\_66496.jpg

View of waterward slope.

Comment Code					
Inspector Comment					
FS_ID:62271 DS_ID:19878 EP_NO: N/A Repair Type: Non-Urgent Crossing Status: Found UCIP Comments: 04/17/2014 Not accessible--crossing is buried on landward side. Need to contact owner to determine status. (O. Magana - DWR UCIP) FIELD_STRUCT_DESC: 24-inch corrugated metal gravity drainage pipe through the levee, 12.3 feet below the crown. Flap gate on the waterside (WS) end. [Additional Reference(s): DWR Levee Log, 2002 (HLM 14.45), listed as a 24-inch corrugated metal pipe (CMP). USACE San Joaquin O&M Manual, Unit 601 Part 1 (SJR601.1), 1967, Revised 25 May 2011, (HLM 14.44), listed as a 24-inch CMP] FS Date: 4/17/2014

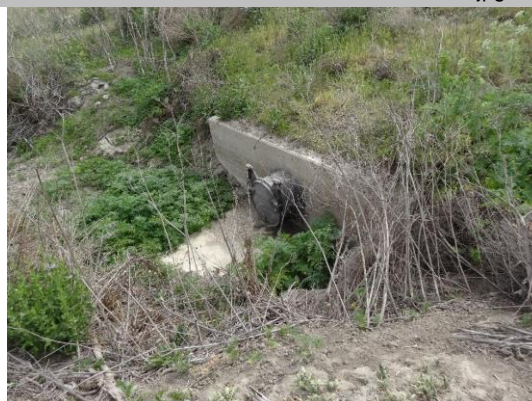
Photo 2 of 3 : UCIP\_SP\_2021\_62271\_66497.jpg

View of pipe daylight, flap gate, and concrete headwall visible on waterward toe.

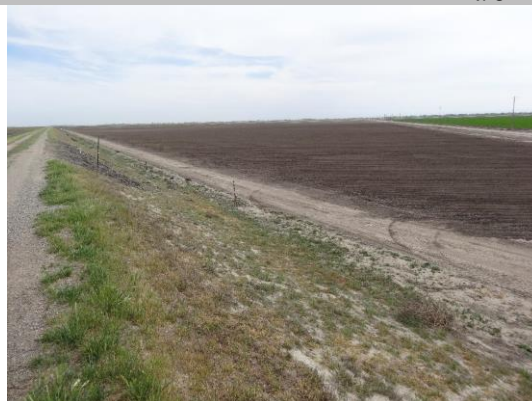
Photo 3 of 3 : UCIP\_SP\_2021\_62271\_66498.jpg

View of landward slope.

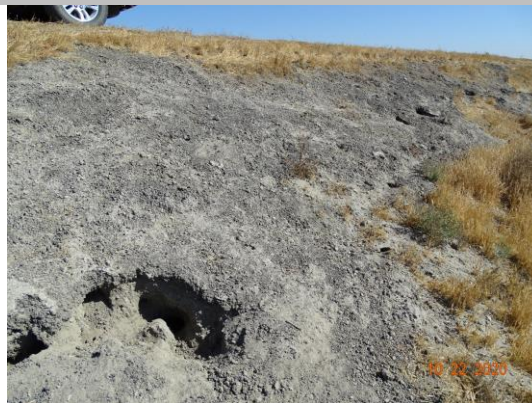
Photo 1 of 1 : SP\_2021\_NA0010\_124\_98\_20210308\_00024.jpg

LM Start	14.37	Rating **	U	Issue No.	98	
LM End	14.37	Issue Type +	Ma	Location *	WS	
Category	Earthen Levee			GPS Latitude/Longitude		
				Start		End
Item	Animal Control			37.167740 °		37.167740 °
				-120.636282 °		-120.636282 °
DWR ID	DWR_NA0010_06_f_2020_98					
Comment Code						
A3 : No rodents visible, but rodent burrows visible; need to backfill and compact or grout burrows.						
Inspector Comment

Looking upstream along the waterside slope. (Fall 2020)

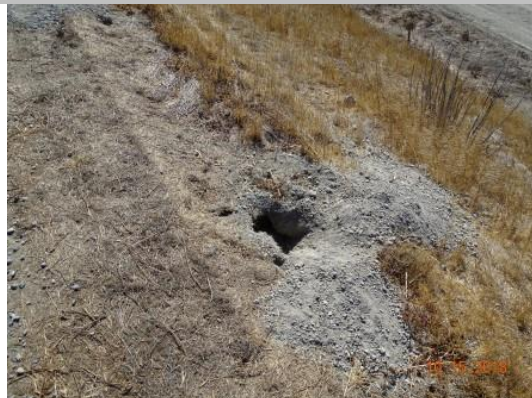
Photo 1 of 1 : SP\_2021\_NA0010\_124\_101\_20210308\_00026.jpg

LM Start	14.63	Rating **	M	Issue No.	101
LM End	14.64	Issue Type +	Ma	Location *	LS
Category	Earthen Levee			GPS Latitude/Longitude	
				Start	End
Item	Animal Control			37.164871 °	37.164824 °
				-120.633222 °	-120.633167 °
DWR ID	DWR_NA0010_06_f_2018_101				
Comment Code					
A3 : No rodents visible, but rodent burrows visible; need to backfill and compact or grout burrows.					
Inspector Comment					
Burrows are located along landside shoulder.

View of rodent hole on landside shoulder. (Fall 2018)

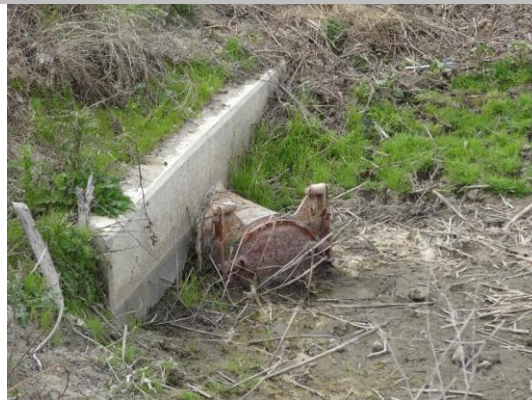
Photo 1 of 3 : UCIP\_SP\_2021\_62272\_66507.jpg

Comment Code					
Inspector Comment					
FS_ID:62272 DS_ID:19884 EP_NO: N/A Repair Type: Non-Urgent Crossing Status: Found UCIP Comments: 04/17/2014 Need to contact owner. Sediment buildup on both the waterward and landward side. Recommend removing sediment buildup from both side. Also recommend clearing excess sediment inside crossing. (O. Magana - DWR UCIP) FIELD_STRUCT_DESC: 24-inch corrugated metal gravity drainage pipe through the levee, 14 feet below the crown. Flap gate on the waterside (WS) end. [Additional Reference(s): DWR Levee Log, 2002 (HLM 15.78), listed as a 24-inch corrugated metal pipe (CMP). USACE San Joaquin O&M Manual, Unit 601 Part 1 (SJR601.1), 1967, Revised 25 May 2011, (HLM 15.76), listed as a 24-inch CMP]. FS Date: 4/17/2014

Flap gate buried halfway on waterward side.

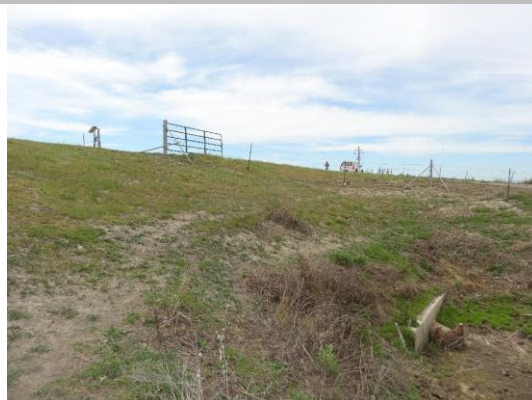
Photo 2 of 3 : UCIP\_SP\_2021\_62272\_66506.jpg

View of waterward side.

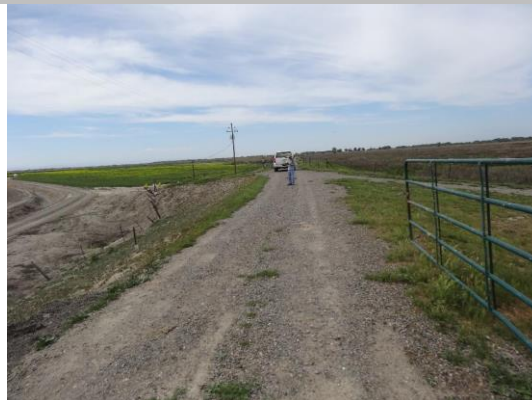
Photo 3 of 3 : UCIP\_SP\_2021\_62272\_66505.jpg

Overview of levee crown at crossing.

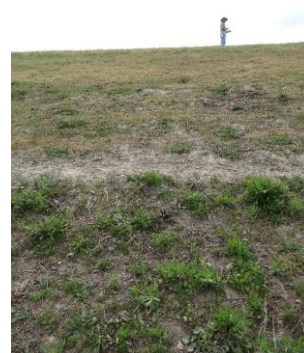
Photo 1 of 3 : UCIP\_SP\_2021\_62273\_66530.jpg

FS\_ID:62273  
DS\_ID:19885  
EP\_NO: N/A  
Repair Type: Non-Urgent  
Crossing Status: Found  
UCIP Comments: 04/17/2014 Need to contact owner to determine status of crossing. Waterward side is buried and not accessible. Landward side headwall is blocked by dense vegetation. Recommend confirming status of flap gate on waterward side and removing dense vegetation from landward side. (O. Magana - DWR UCIP)  
FIELD\_STRUCT\_DESC: 36-inch corrugated metal gravity drainage pipe through the levee, 16.6 feet below the crown. Flap gate on the waterside (WS) end. [Additional Reference(s): DWR Levee Log, 2002 (HLM 15.93), listed as a 36-inch corrugated metal pipe (CMP). USACE San Joaquin O&M Manual, Unit 601 Part 1 (SJR601.1), 1967, Revised 25 May 2011, (HLM 15.91), listed as a 36-inch CMP]  
FS Date: 4/17/2014

View of waterward side, Photo 1 of 3.

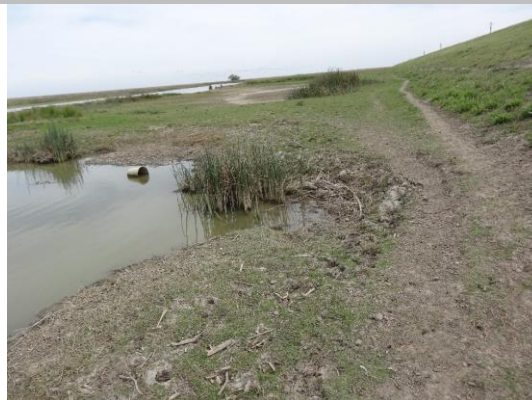
Photo 2 of 3 : UCIP\_SP\_2021\_62273\_66526.jpg

View of waterward side, photo 2 of 3.

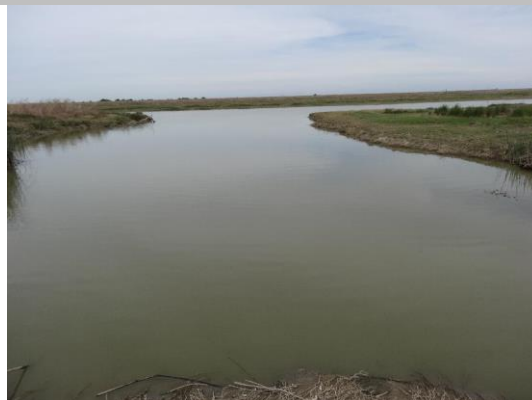
Photo 3 of 3 : UCIP\_SP\_2021\_62273\_66529.jpg

View of waterward side, photo 3 of 3.

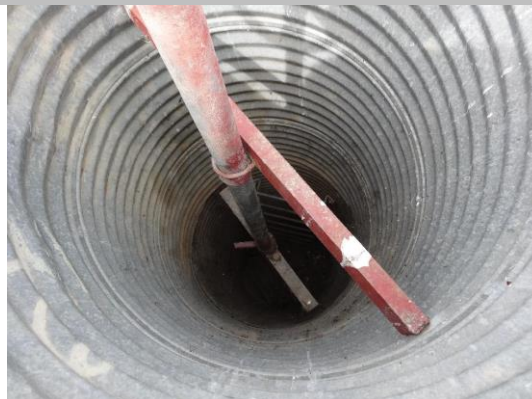
Photo 2 of 3 : UCIP\_SP\_2021\_62277\_66582.jpg

Comment Code						
Inspector Comment						
FS_ID:62277 DS_ID:19889 EP_NO: N/A Repair Type: Non-Urgent Crossing Status: Found UCIP Comments: 04/17/2014 Dense vegetation limits the inspector's visibility to identify signs of pipe failure (leaks) along the landward slope. Recommend removing vegetation along pipe alignment to conduct proper inspection of structure. (O. Magana - DWR UCIP) FIELD_STRUCT_DESC: 24-inch corrugated metal gravity drainage pipe through the levee, 10.2 feet below the crown. Slide gate in a pipe riser on the waterside (WS) slope. [Additional Reference(s): DWR Levee Log, 2002 (HLM 18.98), listed as a 24-inch corrugated metal pipe (CMP). USACE San Joaquin O&M Manual, Unit 601 Part 1 (SJR601.1), 1967, Revised 25 May 2011, (HLM 18.97), listed as a 24-inch CMP]. FS Date: 4/17/2014

Inside view of CMP riser located on waterward slope.

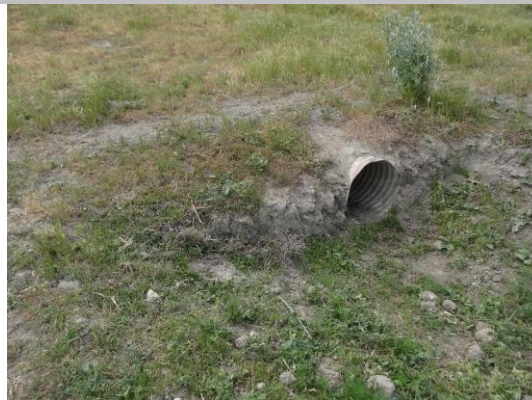
Photo 3 of 3 : UCIP\_SP\_2021\_62277\_66581.jpg

Pipe daylight on waterward side.

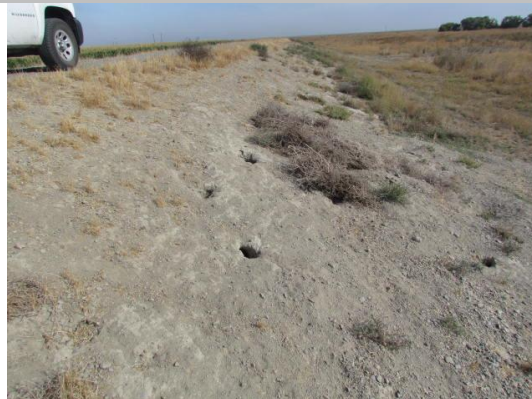
Photo 1 of 1 : SP\_2021\_NA0010\_124\_1211\_20210308\_00038.jpg

LM Start	19.14	Rating **	A/W	Issue No.	1211
LM End	19.14	Issue Type +	Ma	Location *	WS
Category	Earthen Levee			GPS Latitude/Longitude	
				Start	End
Item	Animal Control			37.114793 °	37.114793 °
				-120.587582 °	-120.587582 °
DWR ID	DWR_NA0010_06_s_2015_1211				
Comment Code					
A1 : Exterminate rodents and backfill and compact or grout burrows.					
Inspector Comment					
Several large rodent holes with more than 2 cubic feet of material were previously noted on the waterside slope.

Looking at several rodent holes on waterward slope. (Fall 2015)

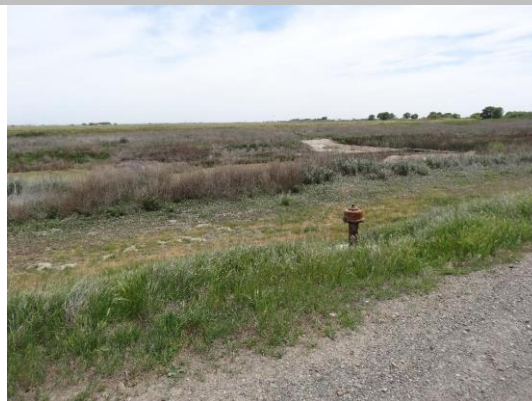
Photo 1 of 3 : UCIP\_SP\_2021\_62278\_66583.jpg

Comment Code					
Inspector Comment					
FS_ID:62278 DS_ID:19890 EP_NO: N/A Repair Type: Non-Urgent Crossing Status: Found UCIP Comments: 04/17/2014 Dense vegetation limits the inspector's visibility to identify signs of pipe failure (leaks) along the slopes. Recommend removing vegetation along pipe alignment to conduct proper inspection of structure. (O. Magana - DWR UCIP) FIELD_STRUCT_DESC: 48-inch corrugated metal gravity drainage pipe through the levee, 20 feet below the crown. Slide gate in a pipe riser on the waterside (WS) slope. Riprap along the landside (LS) slope. [Additional Reference(s): DWR Levee Log, 2002 (HLM 19.36), listed as a 48-inch corrugated metal pipe (CMP). USACE San Joaquin O&M Manual, Unit 601 Part 1 (SJR601.1), 1967, Revised 25 May 2011, (HLM 19.36), listed as a 48-inch CMP]. FS Date: 4/17/2014

View of waterward side.

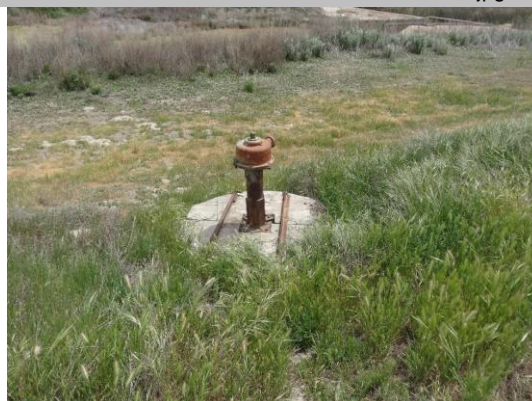
Photo 2 of 3 : UCIP\_SP\_2021\_62278\_66584.jpg

Riser located on waterward slope.

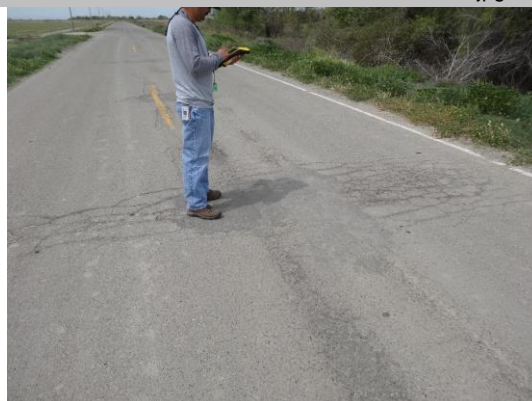
Photo 1 of 3 : UCIP\_SP\_2021\_62279\_66591.jpg

Comment Code					
Inspector Comment					
FS_ID:62279 DS_ID:19891 EP_NO: N/A Repair Type: Non-Urgent Crossing Status: Found UCIP Comments: 04/17/2014 Dense vegetation limits the inspector's visibility to identify signs of pipe failure (leaks) along the slopes. Recommend removing vegetation along pipe alignment to conduct proper inspection of structure. (O. Magana - DWR UCIP) FIELD_STRUCT_DESC: 30-inch by 30-inch reinforced concrete box gravity drainage culvert through the levee, 14 feet below the crown. Flap gate on the waterside (WS) end. [Additional Reference(s): DWR Levee Log, 2002 (HLM 19.82), listed as a 2.5-foot by 2.5-foot reinforced concrete box culvert (RCBC). USACE San Joaquin O&M Manual, Unit 601 Part 1 (SJR601.1), 1967, Revised 25 May 2011, (HLM 19.85), listed as a 2.5-foot by 2.5 foot RCBC]. FS Date: 4/17/2014

Overview of levee crown looking downstream.

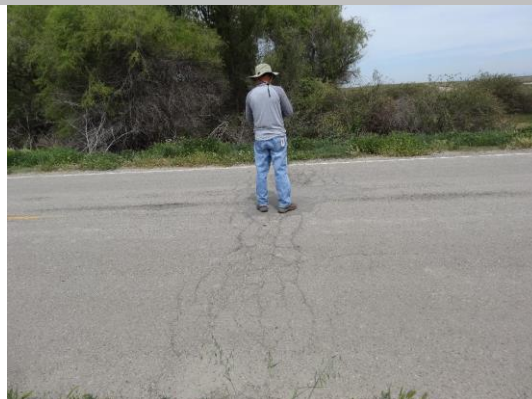
Photo 2 of 3 : UCIP\_SP\_2021\_62279\_66592.jpg

View of levee crown at crossing.

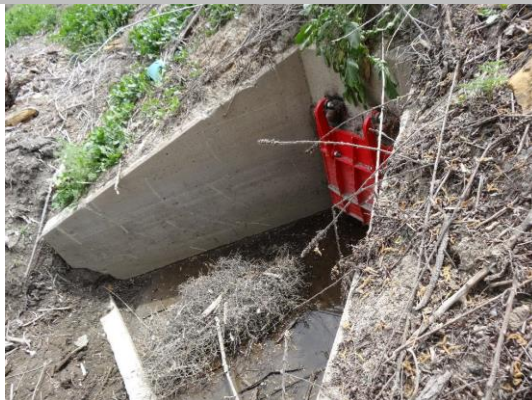
Photo 3 of 3 : UCIP\_SP\_2021\_62279\_66590.jpg

View of "U" concrete headwall located on waterward side.

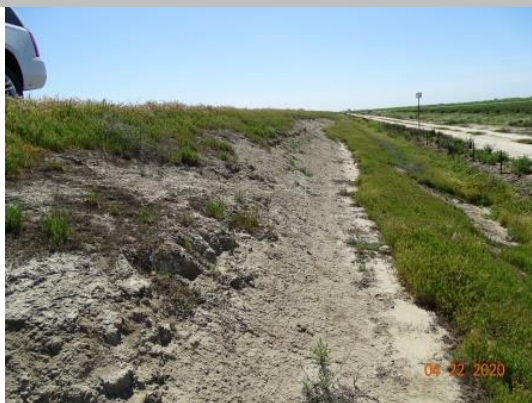
Photo 1 of 1 : SP\_2021\_NA0010\_124\_1209\_20210308\_00037.jpg

LM Start	20.79	Rating **	M	Issue No.	1209
LM End	21.10	Issue Type +	Ma	Location *	LS
Category	Earthen Levee			GPS Latitude/Longitude	
				Start	End
Item	Animal Control			37.113107 °	37.109735 °
				-120.563782 °	-120.560079 °
DWR ID	DWR_NA0010_06_s_2015_1209				
Comment Code					
A2 : Repair the levee slope damaged by livestock and prevent large animal access.					
Inspector Comment					
Erosion on landside slope greater than 3 inches. Erosion caused by livestock.

Erosion on the landside slope from livestock activity. (Spring 2020)

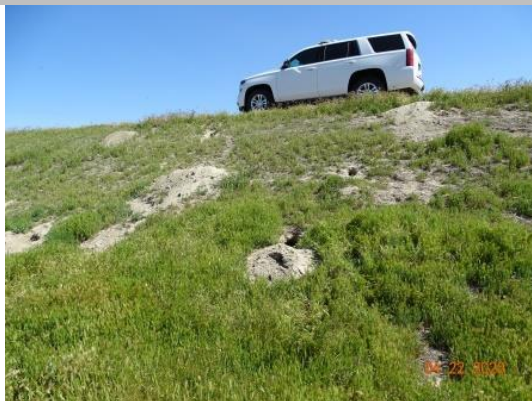
Photo 1 of 1 : SP\_2021\_NA0010\_124\_114\_20210308\_00031.jpg

LM Start	21.39	Rating **	M	Issue No.	114
LM End	21.39	Issue Type +	Ma	Location *	LS
Category	Earthen Levee			GPS Latitude/Longitude	
				Start	End
Item	Animal Control			37.106397 °	37.106397 °
				-120.556727 °	-120.556727 °
DWR ID	DWR_NA0010_06_f_2019_114				
Comment Code					
A3 : No rodents visible, but rodent burrows visible; need to backfill and compact or grout burrows.					
Inspector Comment

View of rodent burrows on the landside slope. (Spring 2020)

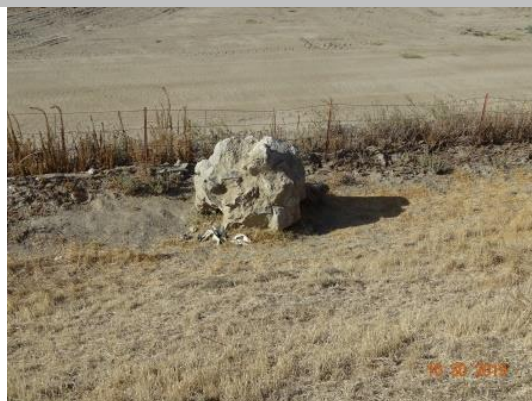
Photo 1 of 1 : SP\_2021\_NA0010\_124\_117\_20210308\_00032.jpg

LM Start	22.87	Rating **	M	Issue No.	117
LM End	22.87	Issue Type +	Ma	Location *	LS
Category	Earthen Levee			GPS Latitude/Longitude	
				Start	End
Item	Encroachments			37.089954 °	37.089954 °
				-120.539535 °	-120.539535 °
DWR ID	DWR_NA0010_06_f_2019_117				
Comment Code					
DE : Debris					
Inspector Comment					
Large block of concrete left on the landside toe.

Large concrete block left on the landside toe. (Fall 2019)

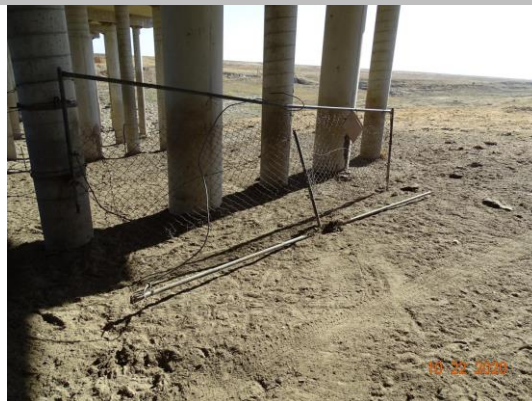
Photo 1 of 1 : SP\_2021\_NA0010\_124\_78\_20210308\_00012.jpg

LM Start	24.46	Rating **	M	Issue No.	78
LM End	24.46	Issue Type +	Ma	Location *	WS
Category	Earthen Levee			GPS Latitude/Longitude	
				Start	End
Item	Repair Gates			37.072606 °	37.072606 °
				-120.520748 °	-120.520748 °
DWR ID	DWR_NA0010_06_f_2020_78				
Comment Code					
Inspector Comment					
Under eastbound 152. Gate in channel under highway 152 should be repaired.

View of damaged access gate under highway 152. (Fall 2020)

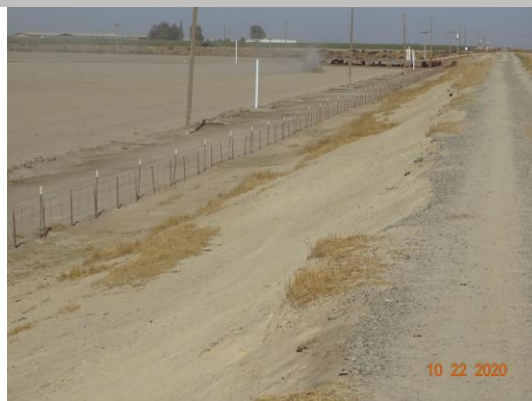
Photo 1 of 1 : SP\_2021\_NA0010\_124\_5\_20210308\_00002.jpg

LM Start	24.51	Rating **	U	Issue No.	5
LM End	25.01	Issue Type +	Ma	Location *	LS
Category	Earthen Levee			GPS Latitude/Longitude	
				Start	End
Item	Animal Control			37.072048 °	37.066501 °
				-120.520180 °	-120.514193 °
DWR ID	DWR_NA0010_06_s_2012_5				
Comment Code					
A2 : Repair the levee slope damaged by livestock and prevent large animal access.					
Inspector Comment					
Landside erosion and slope instability caused by livestock extends into levee crown. At the worst locations erosion extends 2.5 feet to 3 feet from the shoulder into the crown.

Looking downstream at erosion from livestock. (Fall 2020)

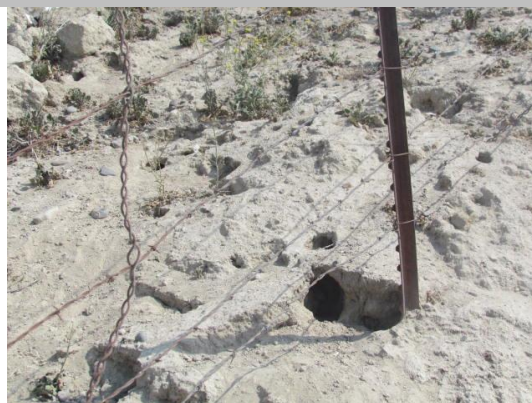
Photo 1 of 1 : SP\_2021\_NA0010\_124\_1208\_20210308\_00036.jpg

LM Start	26.13	Rating **	M	Issue No.	1208
LM End	26.13	Issue Type +	Ma	Location *	LS
Category	Earthen Levee			GPS Latitude/Longitude	
				Start	End
Item	Animal Control			37.054222 °	37.054222 °
				-120.500862 °	-120.500862 °
DWR ID	DWR_NA0010_06_s_2015_1208				
Comment Code					
A3 : No rodents visible, but rodent burrows visible; need to backfill and compact or grout burrows.					
Inspector Comment					
Noted several rodent holes next to and within rock revetment on landside slope.

Rodent holes on landward slope.

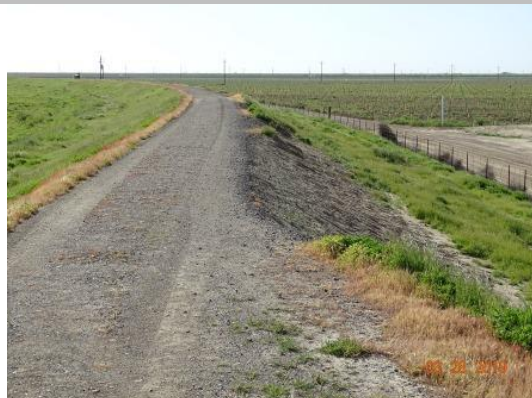
Photo 1 of 1 : SP\_2021\_NA0010\_124\_3\_20210308\_00001.jpg

LM Start	27.43	Rating **	M	Issue No.	3
LM End	27.99	Issue Type +	Ma	Location *	LS
Category	Earthen Levee			GPS Latitude/Longitude	
				Start	End
Item	Animal Control			37.036955 °	37.032762 °
				-120.484395 °	-120.481078 °
DWR ID	DWR_NA0010_06_s_2012_3				
Comment Code					
A2 : Repair the levee slope damaged by livestock and prevent large animal access.					
Inspector Comment					
Landside erosion and slope instability caused by livestock. Erosion greater than 3" in depth on landside slope. Levee crown has narrowed within this reach.

Looking south along landside slope. (Spring 2019)

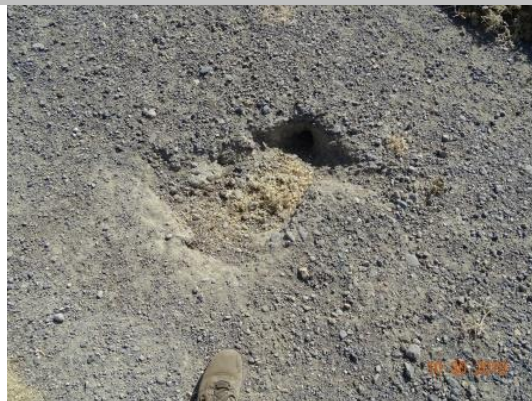
Photo 1 of 1 : SP\_2021\_NA0010\_124\_19\_20210308\_00004.jpg

LM Start	28.47	Rating **	M	Issue No.	19
LM End	28.53	Issue Type +	Ma	Location *	LS
Category	Earthen Levee			GPS Latitude/Longitude	
				Start	End
Item	Animal Control			37.029937 °	37.029977 °
				-120.473384 °	-120.472266 °
DWR ID	DWR_NA0010_06_s_2015_19				
Comment Code					
A3 : No rodents visible, but rodent burrows visible; need to backfill and compact or grout burrows.					
Inspector Comment					
Rodent burrows are also on the crown.

View of rodent burrow in the levee crown. (Fall 2019)

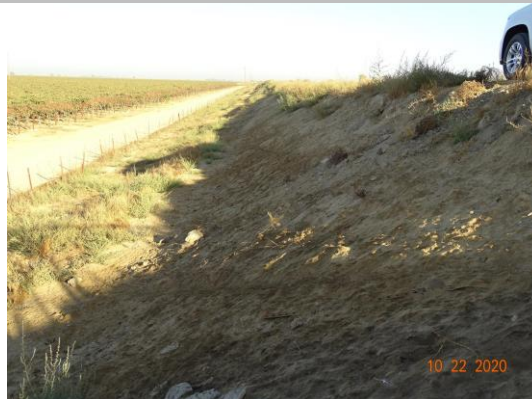
Photo 1 of 1 : SP\_2021\_NA0010\_124\_1207\_20210308\_00035.jpg

LM Start	<b>30.81</b>	Rating **	M	Issue No.	<b>1207</b>
LM End	<b>31.06</b>	Issue Type +	Ma	Location *	LS
Category	Earthen Levee		GPS Latitude/Longitude		
			Start	End	
Item	Animal Control		37.021615 °	37.018428 °	
			-120.437587 °	-120.435378 °	
DWR ID	DWR_NA0010_06_s_2015_1207				
Comment Code					
A2 : Repair the levee slope damaged by livestock and prevent large animal access.					
Inspector Comment					
Landside erosion greater than 1" in depth and greater than 3" in length. Erosion is caused by livestock traffic.

Looking upstream at livestock damage to the landside slope. (Fall 2020)

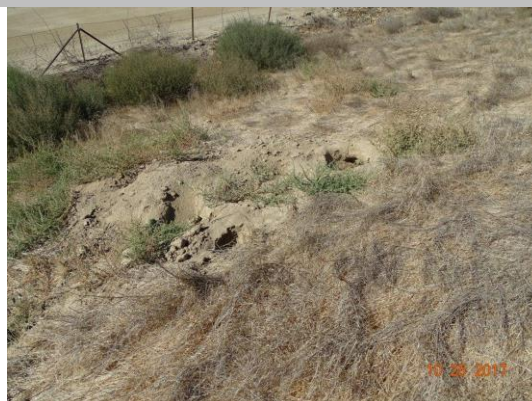
Photo 1 of 1 : SP\_2021\_NA0010\_124\_81\_20210308\_00015.jpg

LM Start	32.00	Rating **	U	Issue No.	81
LM End	32.00	Issue Type +	Ma	Location *	LS
Category	Earthen Levee			GPS Latitude/Longitude	
				Start	End
Item	Animal Control			37.007007 °	37.007007 °
				-120.426179 °	-120.426179 °
DWR ID	DWR_NA0010_06_f_2017_81				
Comment Code					
A3 : No rodents visible, but rodent burrows visible; need to backfill and compact or grout burrows.					
Inspector Comment

Looking west at the landside slope.

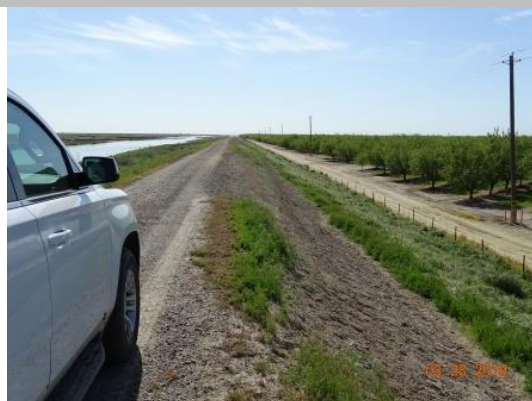
Photo 1 of 1 : SP\_2021\_NA0010\_124\_129\_20210308\_00034.jpg

LM Start	32.50	Rating **	M	Issue No.	129
LM End	32.88	Issue Type +	Ma	Location *	LS
Category	Earthen Levee			GPS Latitude/Longitude	
				Start	End
Item	Animal Control			37.001898 °	36.997745 °
				-120.419861 °	-120.415197 °
DWR ID	DWR_NA0010_06_s_2019_129				
Comment Code					
A2 : Repair the levee slope damaged by livestock and prevent large animal access.					
Inspector Comment					
Slope damage from livestock. Damage is beginning to erode into levee crown.

Erosion from animal activity along the landside slope. (Spring 2019)

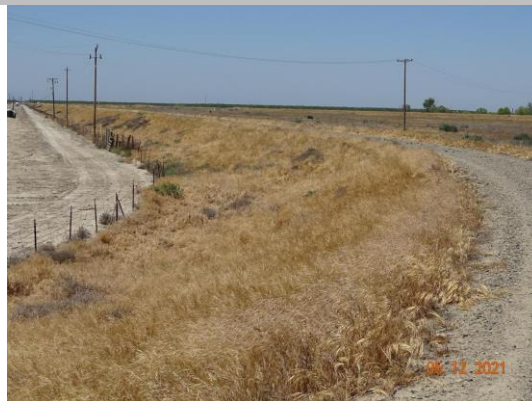
Photo 1 of 1 : SP\_2021\_NA0010\_124\_62\_20210517\_00178.jpg

LM Start	34.04	Rating **	M	Issue No.	62
LM End	36.46	Issue Type +	Ma	Location *	LS
Category	Earthen Levee			GPS Latitude/Longitude	
				Start	End
Item	Vegetation			36.985171 °	36.974171 °
				-120.401278 °	-120.363330 °
DWR ID	DWR_NA0010_06_s_2021_62				
Comment Code					
V1 : Control annual grass and weeds on the levee slopes and easements.					
Inspector Comment

View of vegetation on the landside slope and toe. (Spring 2021)

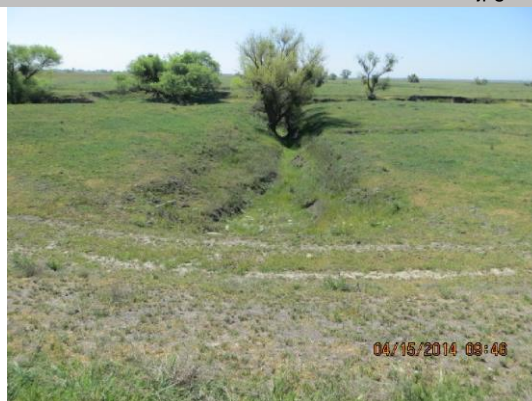
Photo 1 of 3 : UCIP\_SP\_2021\_62031\_60954.jpg

FS\_ID:62031  
DS\_ID:19892  
EP\_NO: N/A  
Repair Type: Non-Urgent  
Crossing Status: Found  
UCIP Comments: 07/20/2016 Inlet blocked off by wooden board. Dense vegetation limits the inspector's visibility to identify signs of pipe failure (leaks) along WS and LS. Crossing downgraded from Urgent to Non-Urgent. (O. Magana - DWR UCIP)04/15/2014 Flapgate partially blocked by soil buildup at WS toe. (W. Wylie - DWR UCIP)  
FIELD\_STRUCT\_DESC: 24-inch corrugated metal gravity drainage pipe through the levee, 10.8 feet below the crown. Flap gate on the waterside (WS) end. Concrete headwall on the landside (LS) end. Concrete U-shaped headwall on the WS end. [Additional Reference(s): DWR Levee Log, 2002 (HLM 0.08), listed as a 24-inch corrugated metal pipe (CMP). USACE San Joaquin O&M Manual, Unit 601 Part 1 (SJR601.1), 1967, (HLM 0.07), listed as a 24-inch CMP].  
FS Date: 7/20/2016

Pipe and headwall at WS toe.

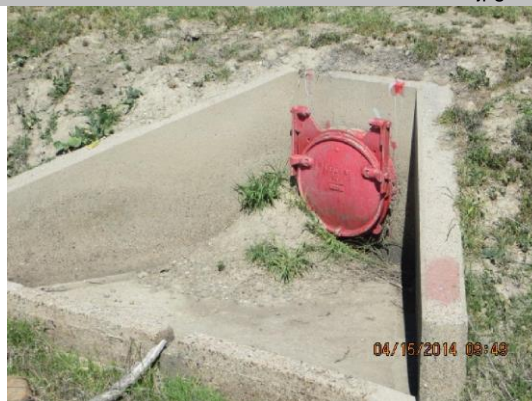
Photo 2 of 3 : UCIP\_SP\_2021\_62031\_60955.jpg

Pipe, headwall, and flapgate at WS toe. Soil buildup partially blocking flapgate.

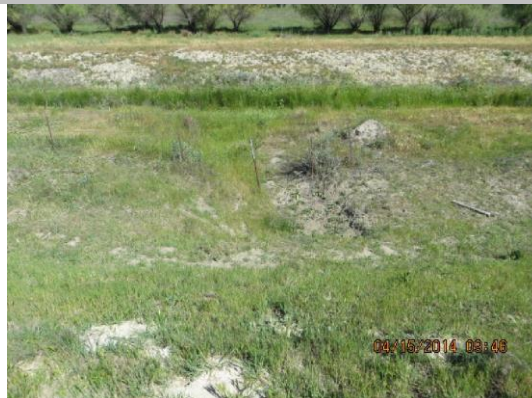
Photo 3 of 3 : UCIP\_SP\_2021\_62031\_60953.jpg

Pipe and headwall at LS toe.

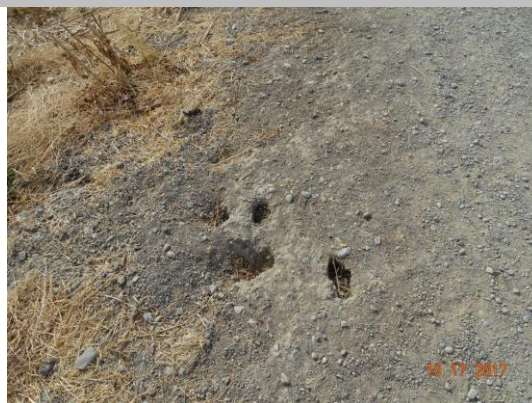
Photo 1 of 1 : SP\_2021\_NA0010\_125\_29\_20210308\_00009.jpg

LM Start	0.24	Rating **	M	Issue No.	29
LM End	0.50	Issue Type +	Ma	Location *	LS
Category	Earthen Levee			GPS Latitude/Longitude	
				Start	End
Item	Animal Control			37.256936 °	37.258722 °
				-120.768472 °	-120.764867 °
DWR ID	DWR_NA0010_07_s_2012_29				
Comment Code					
A3 : No rodents visible, but rodent burrows visible; need to backfill and compact or grout burrows.					
Inspector Comment					
Several rodent holes were noted on the landside and waterside slope and shoulder.

Looking north at landside slope.

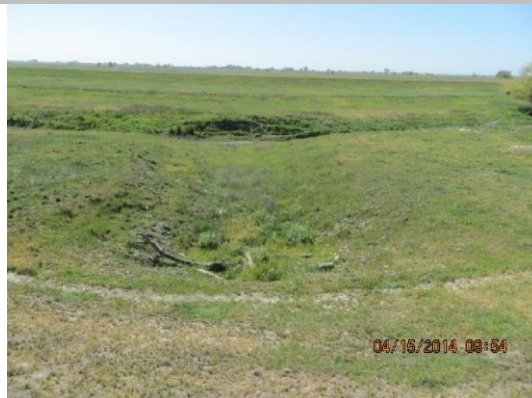
Photo 1 of 3 : UCIP\_SP\_2021\_62044\_60958.jpg

Comment Code						
Inspector Comment						
FS_ID:62044						
DS_ID:19893						
EP_NO: N/A						
Repair Type: No Action Needed						
Crossing Status: Found						
UCIP Comments:						
FIELD_STRUCT_DESC: 24-inch corrugated metal gravity drainage pipe through the levee, 11.1 feet below the crown. Flap gate on the waterside (WS) end. Concrete headwall on the landside (LS) end. Concrete U-shaped headwall on the WS end. [Additional Reference(s): DWR Levee Log, 2002 (HLM 0.34), listed as a 24-inch corrugated metal pipe (CMP). USACE San Joaquin O&M Manual, Unit 601 Part 1 (SJR601.1), 1967, (HLM 0.33), listed as a 24-inch CMP].						
FS Date: 4/15/2014

Pipe and headwall on WS toe.
