**Flood Control Project Maintenance  
Levee Inspections**

## Maintenance Issue Types Only, Levee Inspection Report By Mile - Spring 2021

### Lower San Joaquin Levee District

Waterway	Bank	Unit Miles	Inspection Start/End	Inspector
Unit No. 01 San Joaquin River	Right	22.52	05/04/2021 05/04/2021	Corey Fujitani

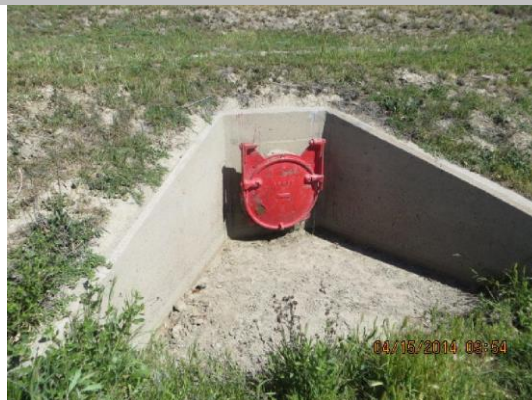
Photo 2 of 3 : UCIP\_SP\_2021\_62044\_60957.jpg

Pipe, headwall, and flapgate on WS toe.

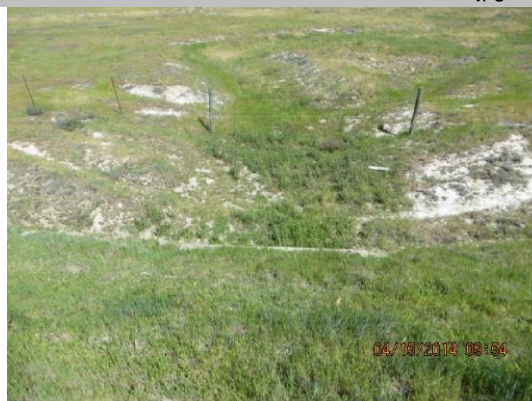
Photo 3 of 3 : UCIP\_SP\_2021\_62044\_60959.jpg

Pipe and headwall on LS toe.

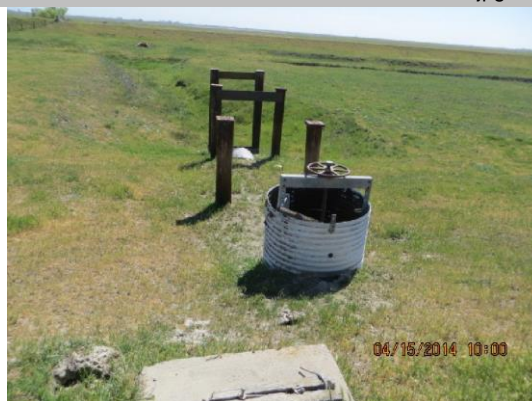
Photo 1 of 3 : UCIP\_SP\_2021\_62042\_60963.jpg

FS\_ID:62042  
DS\_ID:19894  
EP\_NO: N/A  
Repair Type: Non-Urgent  
Crossing Status: Found  
UCIP Comments: 04/15/2014 Slide gate not operable, but left in closed position. Need to reinstall covers over slide gate standpipe. (W. Wylie - DWR UCIP)  
FIELD\_STRUCT\_DESC: 36-inch corrugated metal gravity drainage pipe through the levee, 9.7 feet below the crown. Slide gate in a 48-inch corrugated metal pipe (CMP) riser on the landside (LS) slope. Concrete U-shaped headwall on the LS end. Inlet channel cobble revetted. Dilapidated wooden pier on the waterside (WS). WS slope and outlet ditch cobble revetted. [Additional Reference(s): DWR Levee Log, 2002 (HLM 0.49), listed as a 36-inch corrugated metal pipe (CMP). USACE San Joaquin O&M Manual, Unit 601 Part 1 (SJR601.1), 1967, (HLM 0.49), listed as a 36-inch CMP].  
FS Date: 4/15/2014

Slide gate in CMP riser on WS slope.

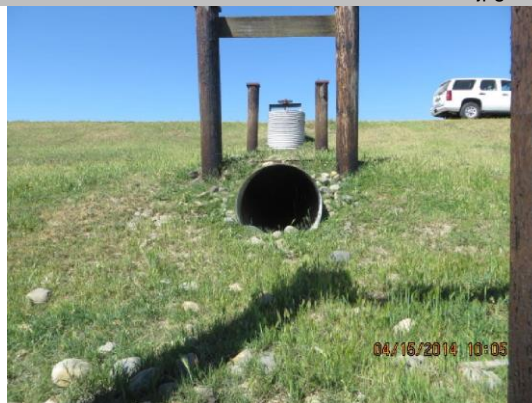
Photo 2 of 3 : UCIP\_SP\_2021\_62042\_60965.jpg

Outlet on WS slope.

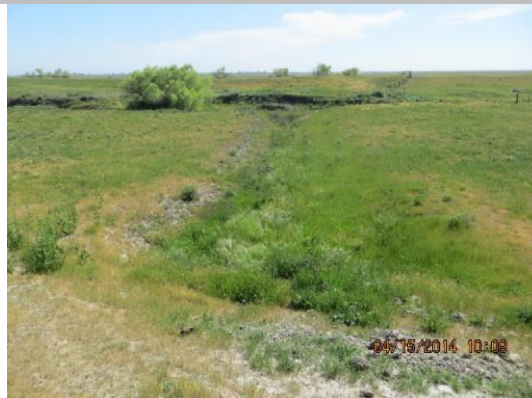
Photo 1 of 3 : UCIP\_SP\_2021\_62045\_60981.jpg

Comment Code						
Inspector Comment						
FS_ID:62045						
DS_ID:19895						
EP_NO: N/A						
Repair Type: No Action Needed						
Crossing Status: Found						
UCIP Comments:						
FIELD_STRUCT_DESC: 24-inch corrugated metal gravity drainage pipe through the levee, 9 feet below the crown. Flap gate on the waterside (WS) end. Concrete headwall with a wooden weir at the inlet on the landside (LS) toe. Concrete U-shaped headwall on the WS toe. [Additional Reference(s): DWR Levee Log, 2002 (HLM 0.53), listed as a 24-inch corrugated metal pipe (CMP). USACE San Joaquin O&M Manual, Unit 601 Part 1 (SJR601.1), 1967, (HLM 0.53), listed as a 24-inch CMP].						
FS Date: 4/15/2014

Headwall and flapgate on WS toe.

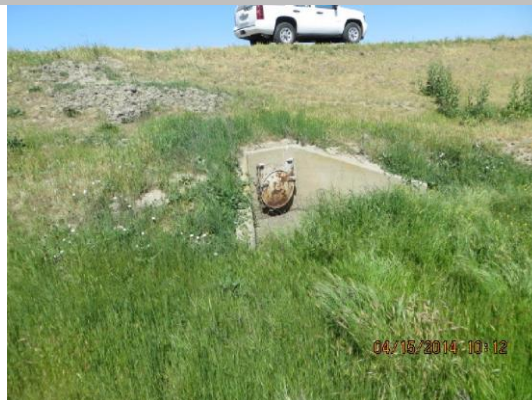
Photo 2 of 3 : UCIP\_SP\_2021\_62045\_60983.jpg

Flapgate on concrete headwall at WS toe.

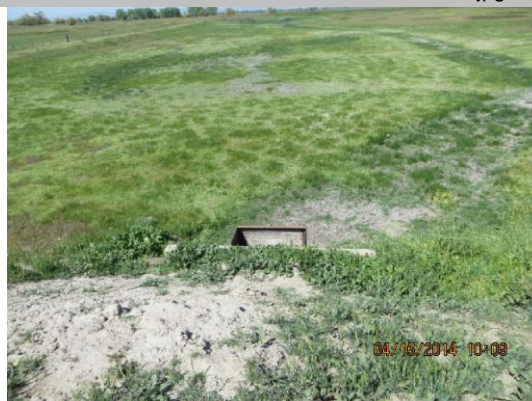
Photo 3 of 3 : UCIP\_SP\_2021\_62045\_60982.jpg

Headwall, pipe, and wier on LS toe.

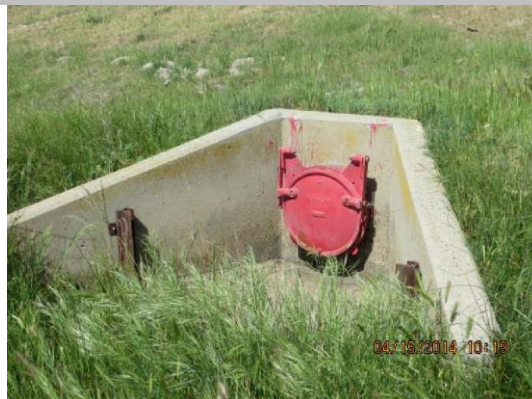
Photo 2 of 3 : UCIP\_SP\_2021\_62035\_60988.jpg

Headwall and flapgate on WS toe.

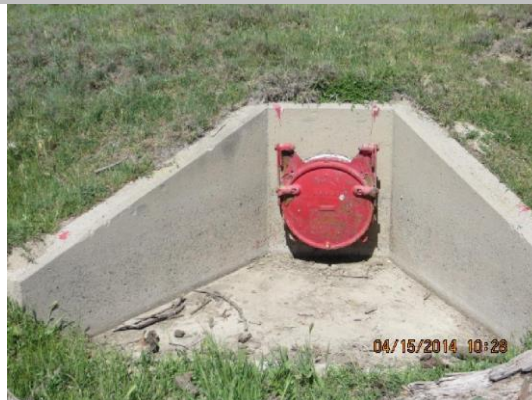
Photo 2 of 3 : UCIP\_SP\_2021\_62036\_60993.jpg

Concrete headwall and flapgate at WS toe.

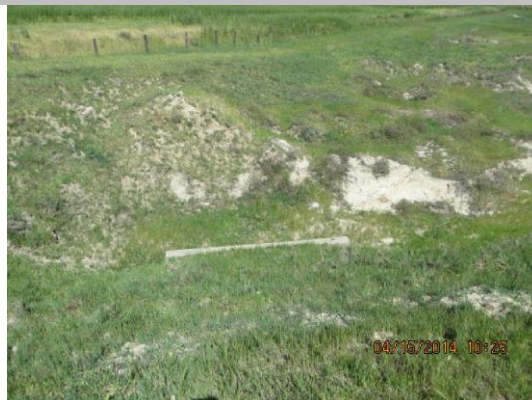
Photo 3 of 3 : UCIP\_SP\_2021\_62036\_60992.jpg

Concrete headwall and pipe on LS toe.

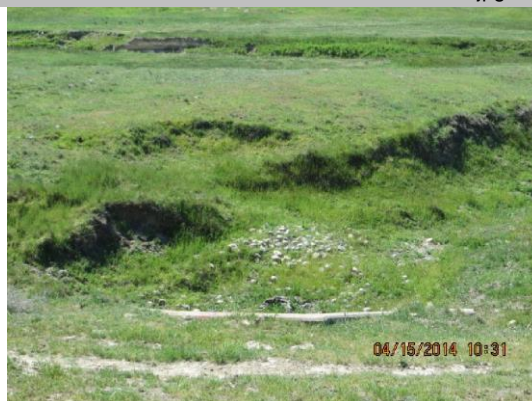
Photo 1 of 3 : UCIP\_SP\_2021\_62043\_60996.jpg

LM Start	1.17	Rating **	A/W	Issue No.	10
LM End	1.17	Issue Type +	Ma	Location *	
Category	Supplemental			GPS Latitude/Longitude	
				Start	End
Item	DWR UCIP LMA Responsibility			37.264421 °	37.264421 °
				-120.756683 °	-120.756683 °
DWR ID	19898				
Comment Code					
Inspector Comment					
FS_ID:62043 DS_ID:19898 EP_NO: N/A Repair Type: No Action Needed Crossing Status: Found UCIP Comments: FIELD_STRUCT_DESC: 48-inch corrugated metal gravity drainage pipe through the levee, 14.6 feet below the crown. Flap gate on the waterside (WS) end. Concrete U-shaped headwall on each end. [Additional Reference(s): DWR Levee Log, 2002 (HLM 1.17), listed as a 48-inch corrugated metal pipe (CMP). USACE San Joaquin O&M Manual, Unit 601 Part 1 (SJR601.1), 1967, (HLM 1.17), listed as a 48-inch CMP]. FS Date: 4/15/2014

Pipe, flapgate, and headwall on WS toe.

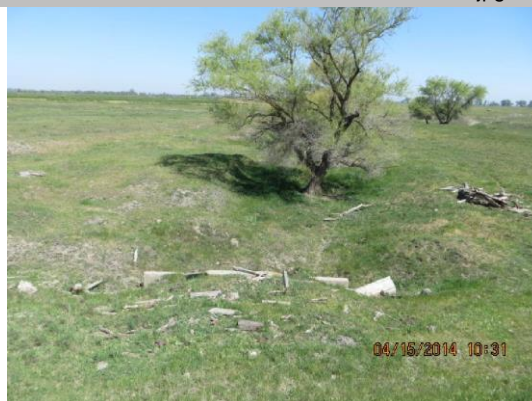
Photo 3 of 3 : UCIP\_SP\_2021\_62043\_60997.jpg

Pipe and headwall on LS toe.

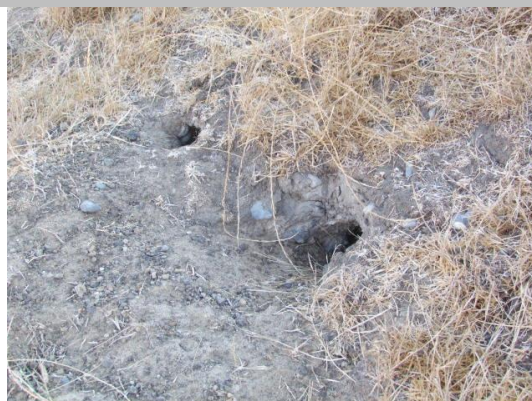
Photo 1 of 1 : SP\_2021\_NA0010\_125\_1\_20210308\_00001.jpg

LM Start	1.22	Rating **	M	Issue No.	1
LM End	1.22	Issue Type +	Ma	Location *	LS
Category	Earthen Levee			GPS Latitude/Longitude	
				Start	End
Item	Animal Control			37.264387 °	37.264387 °
				-120.755805 °	-120.755805 °
DWR ID	DWR_NA0010_07_f_2012_1				
Comment Code					
A1 : Exterminate rodents and backfill and compact or grout burrows.					
Inspector Comment					
Borrows observed in the landside slope and berm.

Looking north at several rodent holes on landward slope.

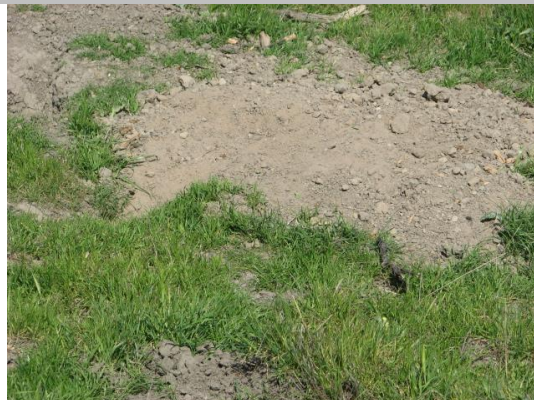
Photo 1 of 1 : SP\_2021\_NA0010\_125\_6\_20210308\_00002.jpg

LM Start	1.50	Rating **	M	Issue No.	6
LM End	1.51	Issue Type +	Ma	Location *	LS
Category	Earthen Levee			GPS Latitude/Longitude	
				Start	End
Item	Animal Control			37.263955 °	37.263885 °
				-120.750751 °	-120.750527 °
DWR ID	DWR_NA0010_07_s_2014_6				
Comment Code					
A1 : Exterminate rodents and backfill and compact or grout burrows.					
Inspector Comment

Looking at typical view of rodent holes within this section. (Spring 2018)

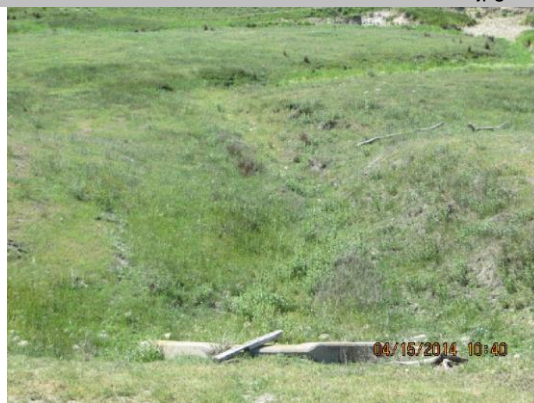
Photo 1 of 3 : UCIP\_SP\_2021\_62038\_61001.jpg

LM Start	1.50	Rating **	A/W	Issue No.	11
LM End	1.50	Issue Type +	Ma	Location *	
Category	Supplemental			GPS Latitude/Longitude	
				Start	End
Item	DWR UCIP LMA Responsibility			37.263917 °	37.263917 °
				-120.750694 °	-120.750694 °
DWR ID	19902				
Comment Code					
Inspector Comment					
FS_ID:62038					
DS_ID:19902					
EP_NO: N/A					
Repair Type: No Action Needed					
Crossing Status: Found					
UCIP Comments:					
FIELD_STRUCT_DESC: 24-inch corrugated metal gravity drainage pipe through the levee, 14 feet below the crown. Flap gate on the waterside (WS) end. Concrete U-shaped headwall on each end. [Additional Reference(s): DWR Levee Log, 2002 (HLM 1.51), listed as a 24-inch corrugated metal pipe (CMP). USACE San Joaquin O&M Manual, Unit 601 Part 1 (SJR601.1), 1967, (HLM 1.51), listed as a 24-inch CMP].					
FS Date: 4/15/2014

Pipe, headwall and flapgate on WS toe.

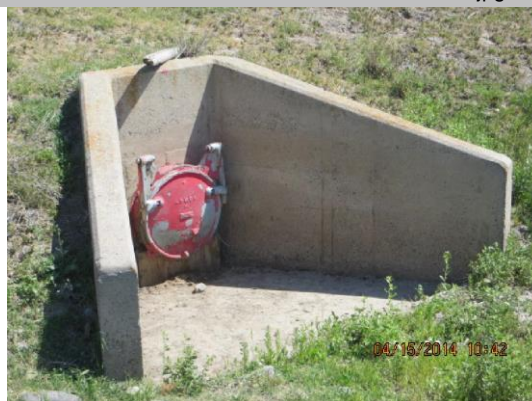
Photo 2 of 3 : UCIP\_SP\_2021\_62038\_61003.jpg

Pipe, headwall and flapgate on WS toe.

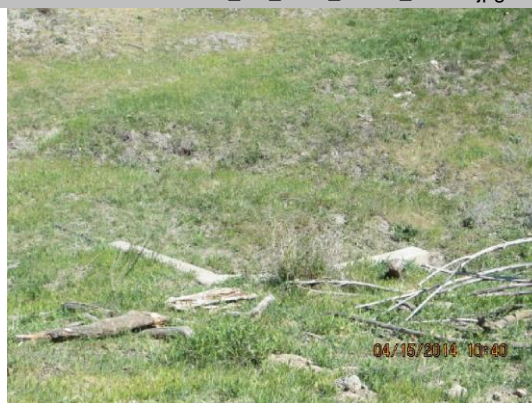
Photo 3 of 3 : UCIP\_SP\_2021\_62038\_61002.jpg

Headwall and pipe on LS toe.

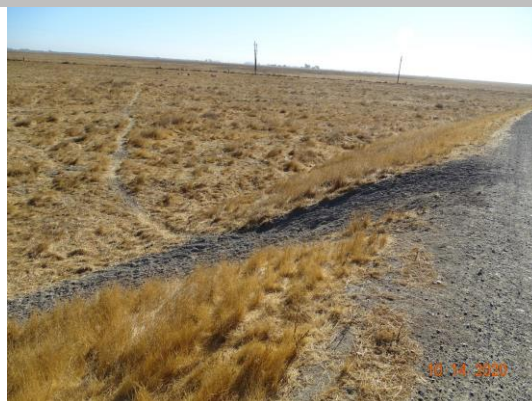
Photo 1 of 1 : SP\_2021\_NA0010\_125\_21\_20210308\_00008.jpg

LM Start	1.90	Rating **	M	Issue No.	21
LM End	1.90	Issue Type +	Ma	Location *	LS
Category	Earthen Levee			GPS Latitude/Longitude	
				Start	End
Item	Animal Control			37.261379 °	37.261379 °
				-120.744228 °	-120.744228 °
DWR ID	DWR_NA0010_07_f_2018_21				
Comment Code					
A2 : Repair the levee slope damaged by livestock and prevent large animal access.					
Inspector Comment

View of damage to the landside slope. (Fall 2020)

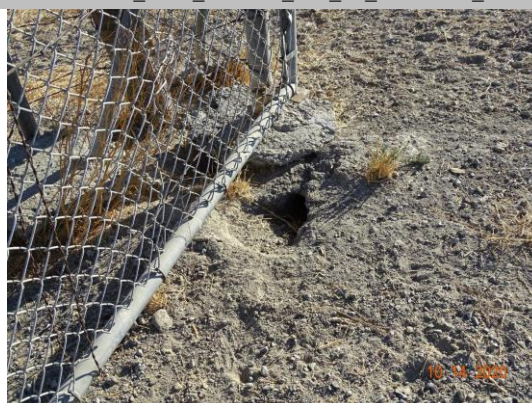
Photo 1 of 1 : SP\_2021\_NA0010\_125\_12\_20210308\_00003.jpg

LM Start	2.09	Rating **	M	Issue No.	12
LM End	2.09	Issue Type +	Ma	Location *	LS
Category	Earthen Levee			GPS Latitude/Longitude	
				Start	End
Item	Animal Control			37.259187 °	37.259187 °
				-120.742551 °	-120.742551 °
DWR ID	DWR_NA0010_07_f_2018_12				
Comment Code					
A3 : No rodents visible, but rodent burrows visible; need to backfill and compact or grout burrows.					
Inspector Comment					
Rodent activity is noted next to the fence post.

View of rodent hole at the fence post on the landside shoulder. (Fall 2020)

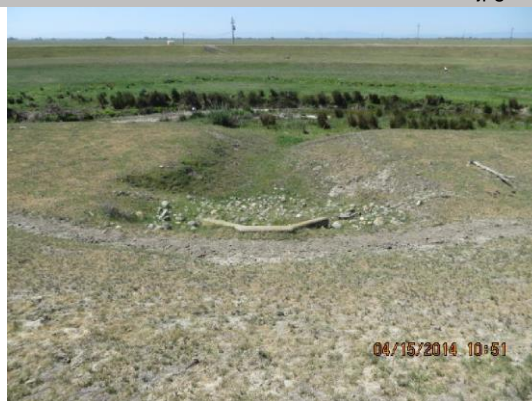
Photo 1 of 3 : UCIP\_SP\_2021\_62039\_61006.jpg

LM Start	2.48	Rating **	A/W	Issue No.	13
LM End	2.48	Issue Type +	Ma	Location *	
Category	Supplemental			GPS Latitude/Longitude	
				Start	End
Item	DWR UCIP LMA Responsibility			37.255803 °	37.255803 °
				-120.737246 °	-120.737246 °
DWR ID	19899				
Comment Code					
Inspector Comment					
FS_ID:62039					
DS_ID:19899					
EP_NO: N/A					
Repair Type: No Action Needed					
Crossing Status: Found					
UCIP Comments:					
FIELD_STRUCT_DESC: 24-inch corrugated metal gravity drainage pipe through the levee, 9.5 feet below the crown. Flap gate on the waterside (WS) end. Concrete headwall on the landside (LS) end. Concrete U-shaped headwall on the WS end. [Additional Reference(s): DWR Levee Log, 2002 (HLM 2.49), listed as a 24-inch corrugated metal pipe (CMP). USACE San Joaquin O&M Manual, Unit 601 Part 1 (SJR601.1), 1967, (HLM 2.48), listed as a 24-inch CMP].					
FS Date: 4/15/2014

Headwall and flapgate on WS toe.

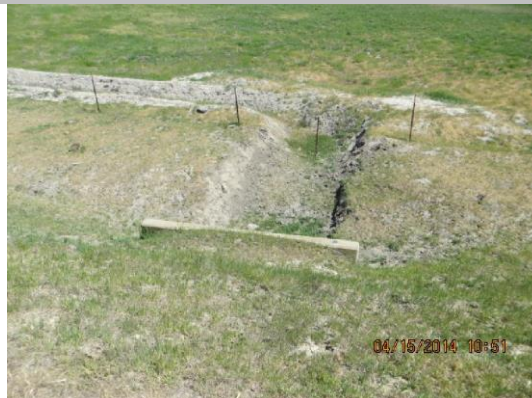
Photo 3 of 3 : UCIP\_SP\_2021\_62039\_61007.jpg

Concrete headwall and pipe on LS toe.

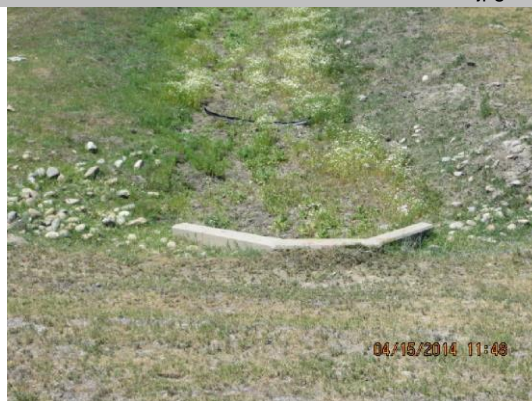
Photo 1 of 3 : UCIP\_SP\_2021\_62040\_61011.jpg

FS\_ID:62040  
 DS\_ID:19900  
 EP\_NO: N/A  
 Repair Type: No Action Needed  
 Crossing Status: Found  
 UCIP Comments:  
 FIELD\_STRUCT\_DESC: 24-inch corrugated metal gravity drainage pipe through the levee, 11.5 feet below the crown. Flap gate on the waterside (WS) end. Concrete headwall on the landside (LS) end. Concrete U-shaped headwall on the WS end. [Additional Reference(s): DWR Levee Log, 2002 (HLM 2.65), listed as a 24-inch corrugated metal pipe (CMP). USACE San Joaquin O&M Manual, Unit 601 Part 1 (SJR601.1), 1967, (HLM 2.64), listed as a 24-inch CMP].  
 FS Date: 4/15/2014

Concrete headwall and flapgate on WS toe.

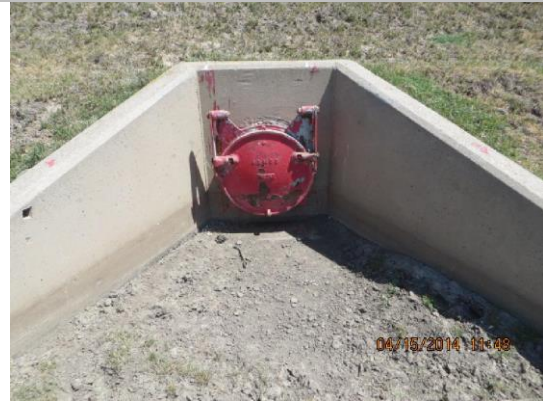
Photo 2 of 3 : UCIP\_SP\_2021\_62040\_61010.jpg

Concrete headwall and flapgate on WS toe.

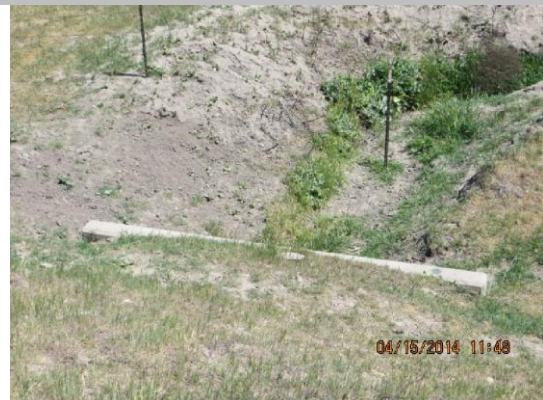
Photo 3 of 3 : UCIP\_SP\_2021\_62040\_61012.jpg

Concrete headwall and pipe at LS toe.

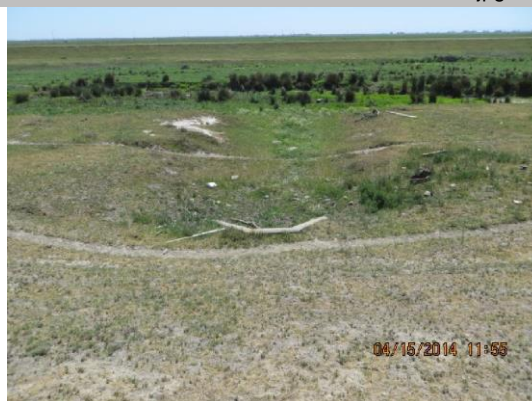
Photo 1 of 3 : UCIP\_SP\_2021\_62041\_61016.jpg

Comment Code						
Inspector Comment						
FS_ID:62041						
DS_ID:19901						
EP_NO: N/A						
Repair Type: Non-Urgent						
Crossing Status: Found						
UCIP Comments: 04/15/2014 Some sediment buildup at landward toe and inside pipe--recommend clearing. (W. Wylie - DWR UCIP)						
FIELD_STRUCT_DESC: 24-inch corrugated metal gravity drainage pipe through the levee, 10.4 feet below the crown. Flap gate on the waterside (WS) end. Concrete headwall on the landside (LS) end. Concrete U-shaped headwall on the WS end. [Additional Reference(s): DWR Levee Log, 2002 (HLM 3.09), listed as a 24-inch corrugated metal pipe (CMP). USACE San Joaquin O&M Manual, Unit 601 Part 1 (SJR601.1), 1967, (HLM 3.09), listed as a 24-inch CMP].						
FS Date: 4/15/2014

Headwall, pipe, and flapgate on WS toe.

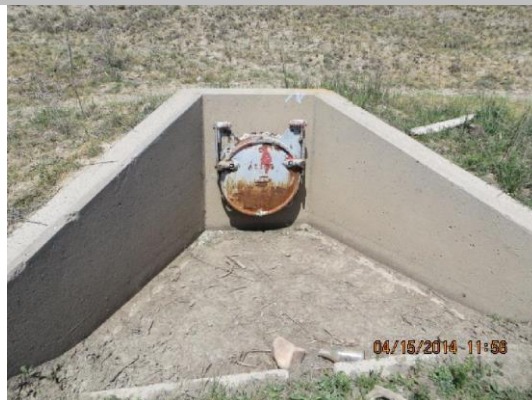
Photo 2 of 3 : UCIP\_SP\_2021\_62041\_61015.jpg

Headwall, pipe, and flapgate on WS toe.

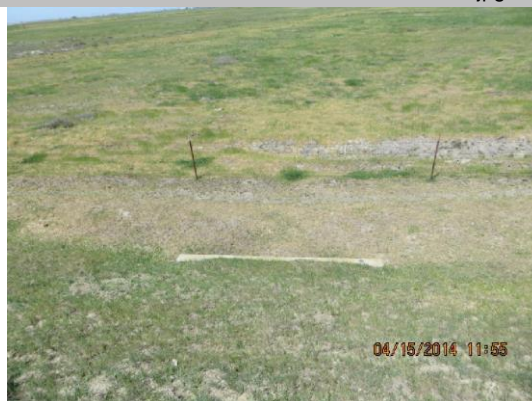
Photo 3 of 3 : UCIP\_SP\_2021\_62041\_61017.jpg

Headwall and pipe on LS toe.

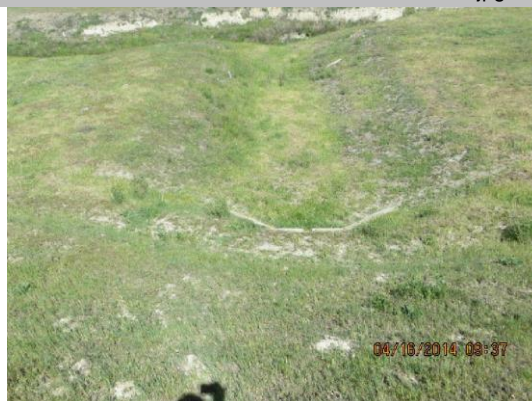
Photo 1 of 3 : UCIP\_SP\_2021\_62046\_61068.jpg

Comment Code						
Inspector Comment						
FS_ID:62046						
DS_ID:19903						
EP_NO: N/A						
Repair Type: No Action Needed						
Crossing Status: Found						
UCIP Comments:						
FIELD_STRUCT_DESC: 24-inch corrugated metal gravity drainage pipe through the levee, 9.6 feet below the crown. Flap gate on the waterside (WS) end. Concrete headwall on the landside (LS) end. Concrete U-shaped headwall on the WS end. [Additional Reference(s): DWR Levee Log, 2002 (HLM 0.23), listed as a 24-inch corrugated metal pipe (CMP). USACE San Joaquin O&M Manual, Unit 601 Part 1 (SJR601.1), 1967, (HLM 0.23), listed as a 24-inch CMP].						
FS Date: 4/16/2014

Headwall and flapgate on WS toe.

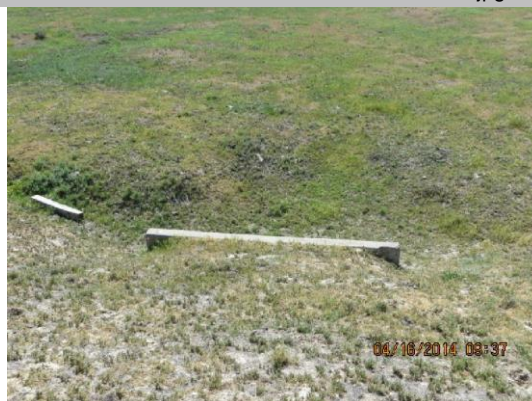
Photo 3 of 3 : UCIP\_SP\_2021\_62046\_61069.jpg

Concrete headwall on LS toe.

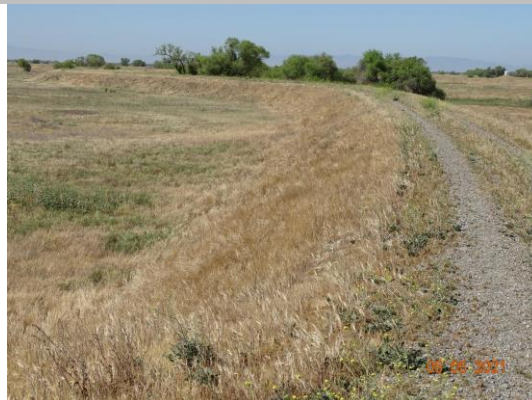
Photo 1 of 1 : SP\_2021\_NA0010\_126\_23\_20210518\_00046.jpg

LM Start	0.57	Rating **	M	Issue No.	23
LM End	0.88	Issue Type +	Ma	Location *	LS
Category	Earthen Levee			GPS Latitude/Longitude	
				Start	End
Item	Vegetation			37.258587 °	37.262263 °
				-120.763583 °	-120.760829 °
DWR ID	DWR_NA0010_08_s_2021_23				
Comment Code					
V1 : Control annual grass and weeds on the levee slopes and easements.					
Inspector Comment

View of the landside slope looking downstream. (Spring 2021)

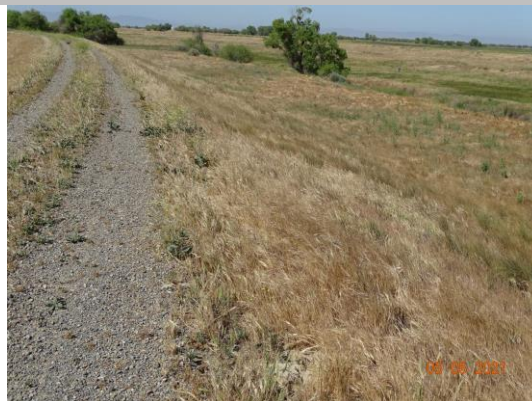
Photo 1 of 1 : SP\_2021\_NA0010\_126\_27\_20210518\_00045.jpg

LM Start	0.57	Rating **	M	Issue No.	27
LM End	0.88	Issue Type +	Ma	Location *	WS
Category	Earthen Levee			GPS Latitude/Longitude	
				Start	End
Item	Vegetation			37.258587 °	37.262263 °
				-120.763583 °	-120.760829 °
DWR ID	DWR_NA0010_08_s_2021_27				
Comment Code					
V1 : Control annual grass and weeds on the levee slopes and easements.					
Inspector Comment

Looking downstream along the waterside slope. (Spring 2021)

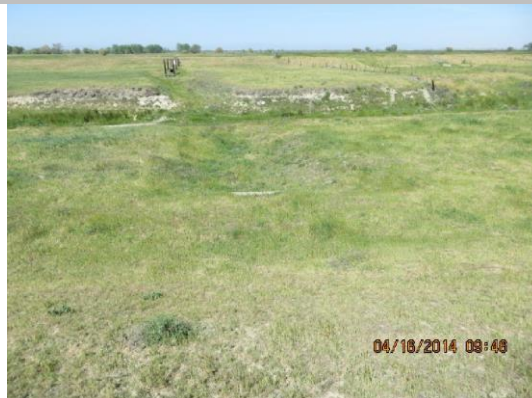
Photo 1 of 3 : UCIP\_SP\_2021\_62047\_61073.jpg

LM Start	0.57	Rating **	A/W	Issue No.	4
LM End	0.57	Issue Type +	Ma	Location *	
Category	Supplemental			GPS Latitude/Longitude	
				Start	End
Item	DWR UCIP LMA Responsibility			37.258604 °	37.258604 °
				-120.763588 °	-120.763588 °
DWR ID	19904				
Comment Code					
Inspector Comment					
FS_ID:62047 DS_ID:19904 EP_NO: N/A Repair Type: No Action Needed Crossing Status: Found UCIP Comments: FIELD_STRUCT_DESC: 24-inch corrugated metal gravity drainage pipe through the levee, 12.4 feet below the crown. Flap gate on the waterside (WS) end. Concrete headwall on each end. [Additional Reference(s): DWR Levee Log, 2002 (HLM 0.55), listed as a 24-inch corrugated metal pipe (CMP). USACE San Joaquin O&M Manual, Unit 601 Part 1 (SJR601.1), 1967, (HLM 0.57), listed as a 24-inch CMP]. FS Date: 4/16/2014

Pipe, flapgate and headwall on WS toe.

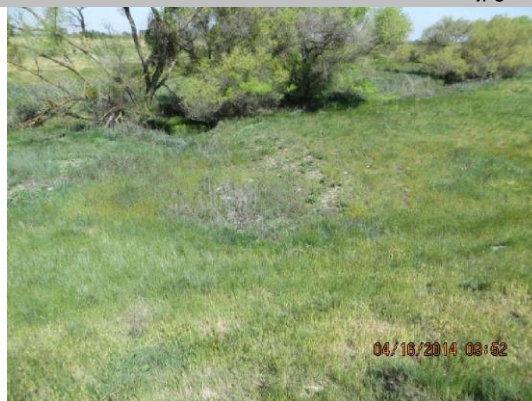
Photo 1 of 3 : UCIP\_SP\_2021\_62048\_61078.jpg

FS\_ID:62048  
DS\_ID:19905  
EP\_NO: N/A  
Repair Type: No Action Needed  
Crossing Status: Found  
UCIP Comments:  
FIELD\_STRUCT\_DESC: 24-inch corrugated metal gravity drainage pipe through the levee, 10 feet below the crown. Flap gate on the waterside (WS) end. Concrete headwall on each end. [Additional Reference(s): DWR Levee Log, 2002 (HLM 0.70), listed as a 24-inch corrugated metal pipe (CMP). USACE San Joaquin O&M Manual, Unit 601 Part 1 (SJR601.1), 1967, (HLM 0.72), listed as a 24-inch CMP].  
FS Date: 4/16/2014

Headwall and flapgate at WS toe.

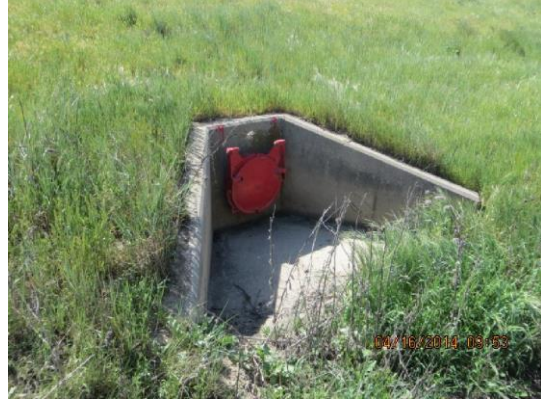
Photo 2 of 3 : UCIP\_SP\_2021\_62048\_61080.jpg

Headwall and flapgate at WS toe.

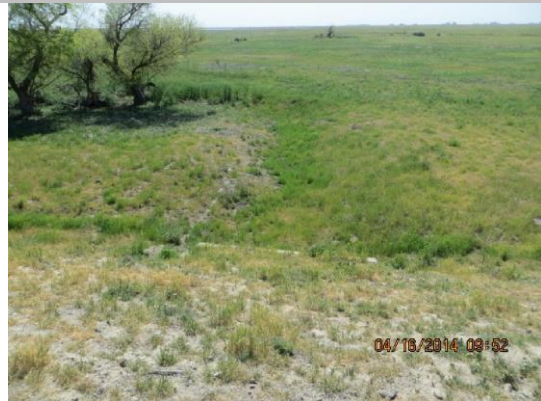
Photo 3 of 3 : UCIP\_SP\_2021\_62048\_61079.jpg

Concrete headwall on LS toe.

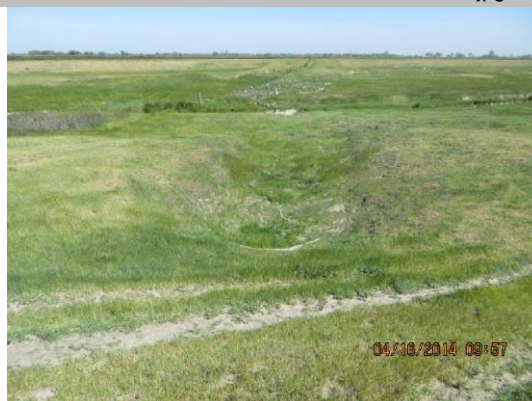
Photo 1 of 3 : UCIP\_SP\_2021\_62049\_61084.jpg

Comment Code						
Inspector Comment						
FS_ID:62049						
DS_ID:19832						
EP_NO: N/A						
Repair Type: Non-Urgent						
Crossing Status: Found						
UCIP Comments: 04/16/2014 Some sediment buildup at inlet on LS toe. (W. Wylie - DWR UCIP)						
FIELD_STRUCT_DESC: 24-inch corrugated metal gravity drainage pipe through the levee, 11.5 feet below the crown. Flap gate on the waterside (WS) end. Concrete headwall on each end. [Additional Reference(s): DWR Levee Log, 2002 (HLM 0.88), listed as a 24-inch corrugated metal pipe (CMP). USACE San Joaquin O&M Manual, Unit 601 Part 1 (SJR601.1), 1967, (HLM 0.89), listed as a 24-inch CMP].						
FS Date: 4/16/2014

Headwall, pipe, and flapgate on WS toe.

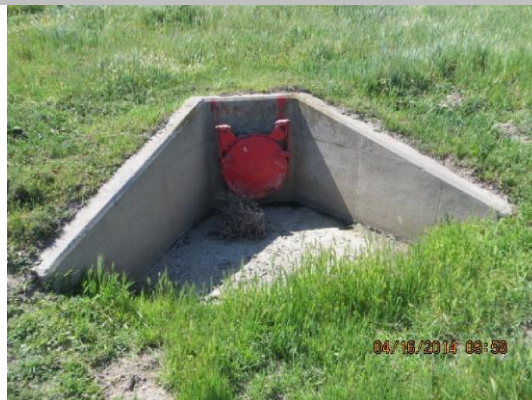
Photo 2 of 3 : UCIP\_SP\_2021\_62049\_61083.jpg

Headwall, pipe, and flapgate on WS toe.

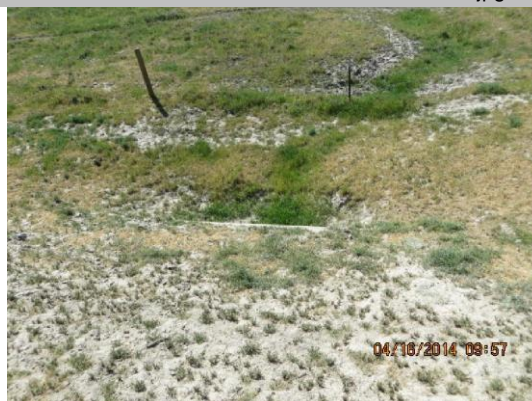
Photo 3 of 3 : UCIP\_SP\_2021\_62049\_61085.jpg

Pipe and headwall on LS toe.

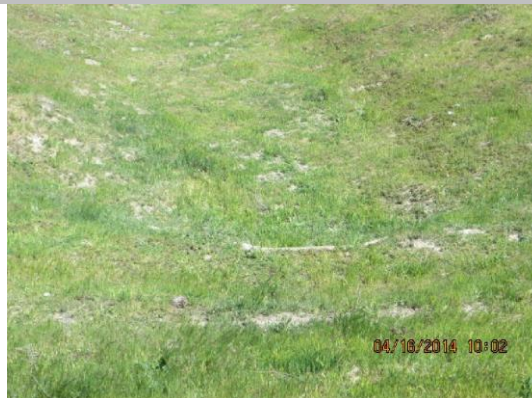
Photo 1 of 3 : UCIP\_SP\_2021\_62050\_61090.jpg

Comment Code						
Inspector Comment						
FS_ID:62050						
DS_ID:19833						
EP_NO: N/A						
Repair Type: Non-Urgent						
Crossing Status: Found						
UCIP Comments: 04/16/2014 Debris blocking landward headwall--recommend clearing. (W. Wylie - DWR UCIP)						
FIELD_STRUCT_DESC: 24-inch corrugated metal gravity drainage pipe through the levee, 11.6 feet below the crown. Flap gate on the waterside (WS) end. Concrete headwall on each end. [Additional Reference(s): DWR Levee Log, 2002 (HLM 1.20), listed as a 24-inch corrugated metal pipe (CMP). USACE San Joaquin O&M Manual, Unit 601 Part 1 (SJR601.1), 1967, (HLM 1.21), listed as a 24-inch CMP].						
FS Date: 4/16/2014

Concrete headwall, pipe, and flapgate on WS toe.

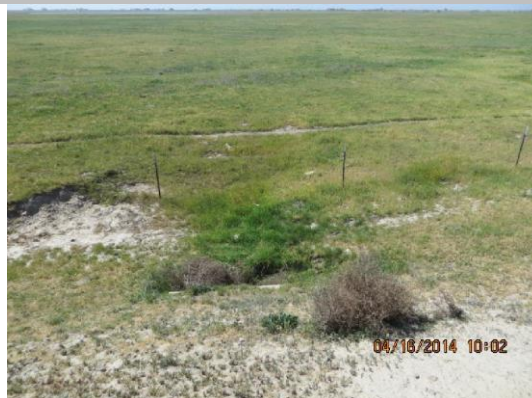
Photo 3 of 3 : UCIP\_SP\_2021\_62050\_61089.jpg

Pipe and headwall on LS toe.

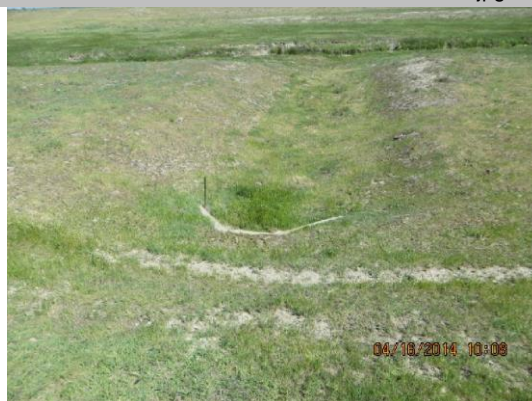
Photo 1 of 3 : UCIP\_SP\_2021\_62051\_61094.jpg

Pipe, headwall, and flapgate on WS toe.

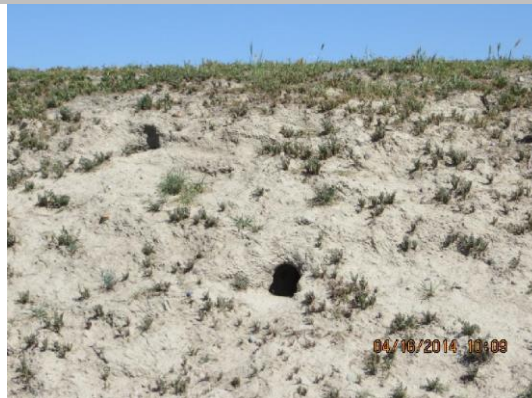
Photo 3 of 3 : UCIP\_SP\_2021\_62051\_61095.jpg

Comment Code					
Inspector Comment					
FS_ID:62051 DS_ID:19834 EP_NO: N/A Repair Type: Non-Urgent Crossing Status: Found UCIP Comments: 04/16/2014 Animal burrows along pipe alignment on LS. Some sediment buildup at LS toe and inside pipe--recommend clearing. (W. Wylie -DWR UCIP) FIELD_STRUCT_DESC: 24-inch corrugated metal gravity drainage pipe through the levee, 11.5 feet below the crown. Flap gate on the waterside (WS) end. Concrete headwall on each end. [Additional Reference(s): DWR Levee Log, 2002 (HLM 1.37), listed as a 24-inch corrugated metal pipe (CMP). USACE San Joaquin O&M Manual, Unit 601 Part 1 (SJR601.1), 1967, (HLM 1.38), listed as a 24-inch CMP]. FS Date: 4/16/2014

Animal burrows along alignment on LS slope.

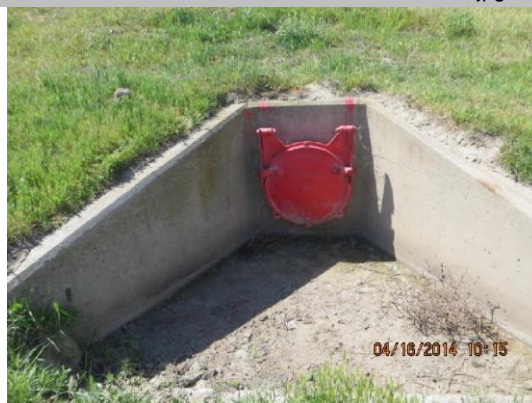
Photo 1 of 3 : UCIP\_SP\_2021\_62052\_61098.jpg

Pipe, headwall, and flapgate on Ws toe.

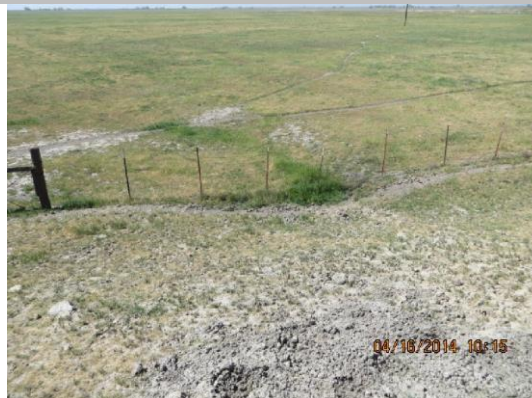
Photo 2 of 3 : UCIP\_SP\_2021\_62052\_61099.jpg

Comment Code						
Inspector Comment						
FS_ID:62052 DS_ID:19835 EP_NO: N/A Repair Type: Non-Urgent Crossing Status: Found UCIP Comments: 04/16/2014 Non-functional landward inlet is buried in sediment. Need to contact owner to determine status. (W. Wylie - DWR UCIP) FIELD_STRUCT_DESC: 24-inch corrugated metal gravity drainage pipe through the levee, 12 feet below the crown. Flap gate on the waterside (WS) end. Concrete headwall on each end. [Additional Reference(s): DWR Levee Log, 2002 (HLM 2.04), listed as a 24-inch corrugated metal pipe (CMP). USACE San Joaquin O&M Manual, Unit 601 Part 1 (SJR601.1), 1967, (HLM 2.05), listed as a 24-inch CMP]. FS Date: 4/16/2014

Pipe and headwall buried in sediment at LS toe.

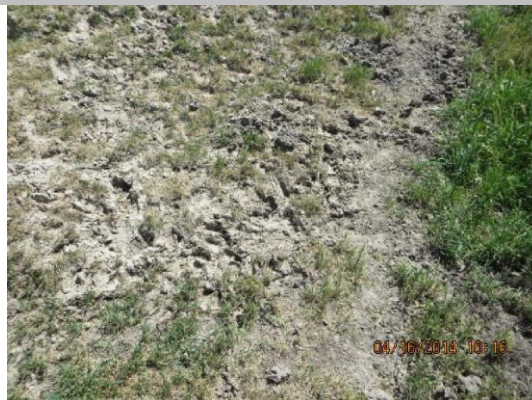
Photo 3 of 3 : UCIP\_SP\_2021\_62052\_61097.jpg

Pipe and headwall buried in sediment at LS toe.

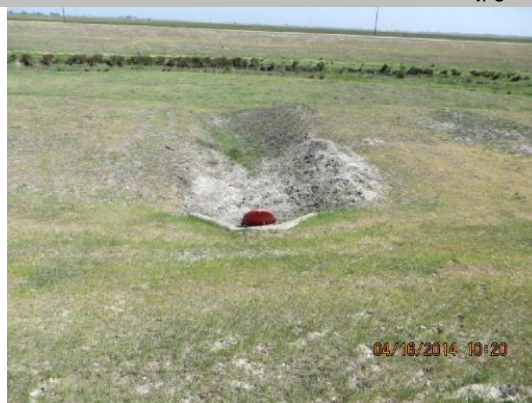
Photo 1 of 3 : UCIP\_SP\_2021\_62053\_61102.jpg

Pipe, headwall, and flapgate on WS toe.

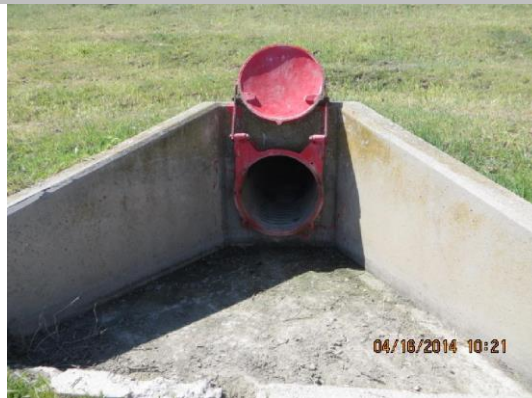
Photo 2 of 3 : UCIP\_SP\_2021\_62053\_61100.jpg

Pipe, headwall, and flapgate on WS toe.

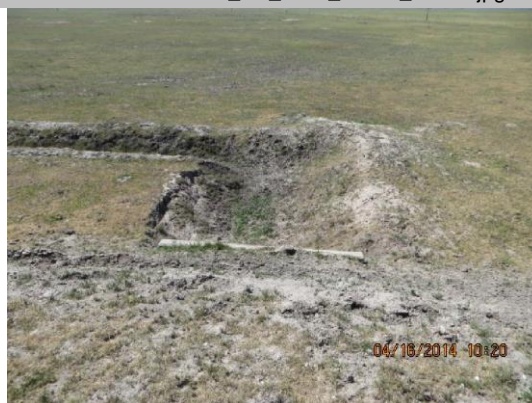
Photo 3 of 3 : UCIP\_SP\_2021\_62053\_61101.jpg

Pipe and headwall on LS toe.

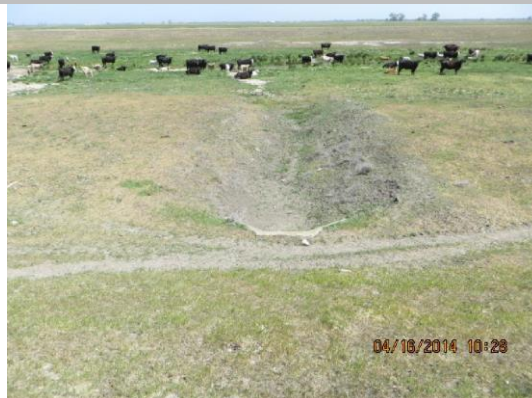
Photo 1 of 3 : UCIP\_SP\_2021\_62054\_61107.jpg

Pipe, headwall, and flapgate on Ws toe.

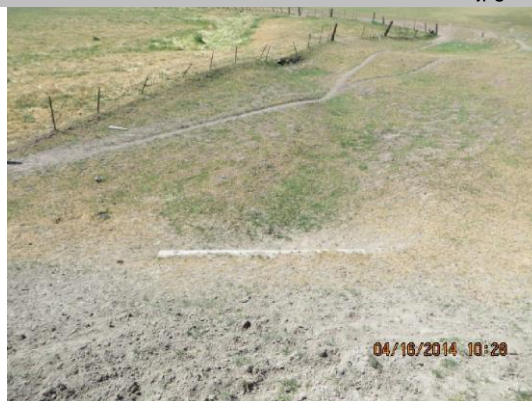
Photo 3 of 3 : UCIP\_SP\_2021\_62054\_61106.jpg

Pipe and headwall on LS toe.

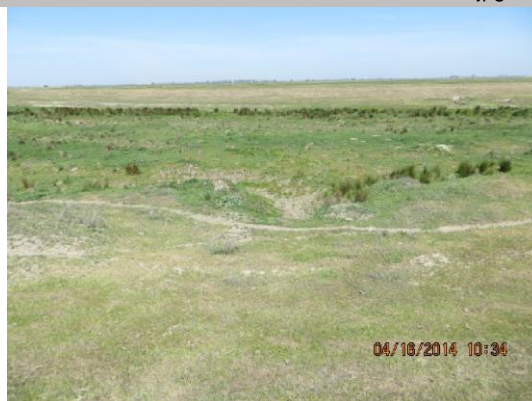
Photo 1 of 3 : UCIP\_SP\_2021\_62058\_61112.jpg

FS\_ID:62058  
 DS\_ID:19838  
 EP\_NO: N/A  
 Repair Type: Non-Urgent  
 Crossing Status: Found  
 UCIP Comments: 7/20/2016 LS inlet buried under dense vegetation. Dense vegetation limits the inspector's visibility to identify signs of pipe failure (leaks) along the WS and LS slope. Recommend removing vegetation along pipe alignment to conduct proper inspection of structure and appurtenances. (O. Magana - DWR UCIP)4/16/2014 Pipe blocked by silt on LS toe. Flapgate rusty and does not operate correctly. (W. Wylie - DWR UCIP)  
 FIELD\_STRUCT\_DESC: 36-inch corrugated metal gravity drainage pipe through the levee, 13.4 feet below the crown. Flap gate on the waterside (WS) end. Concrete headwall on each end. [Additional Reference(s): DWR Levee Log, 2002 (HLM 3.06), listed as a 36-inch corrugated metal pipe (CMP). USACE San Joaquin O&M Manual, Unit 601 Part 1 (SJR601.1), 1967, (HLM 3.06), listed as a 36-inch CMP].

Pipe, headwall, and flapgate on WS toe.

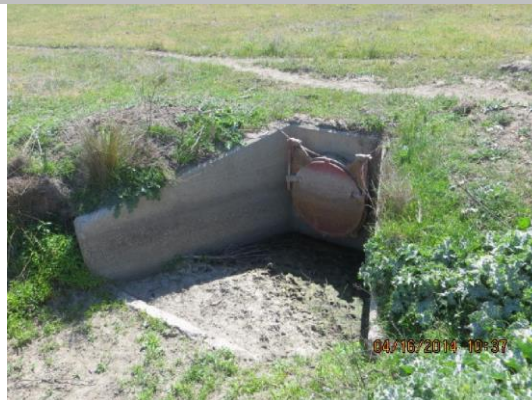
Photo 2 of 3 : UCIP\_SP\_2021\_62058\_61113.jpg

Pipe, headwall, and flapgate on WS toe.

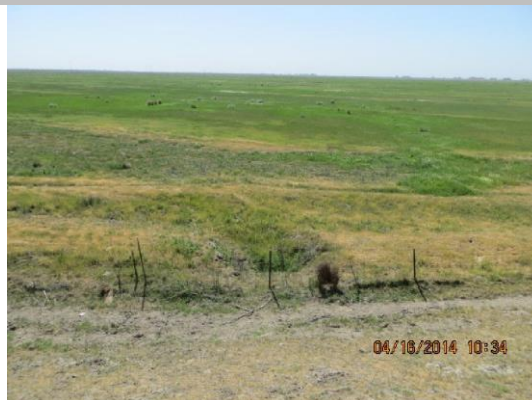
Photo 3 of 3 : UCIP\_SP\_2021\_62058\_61111.jpg

Pipe and headwall on LS toe.

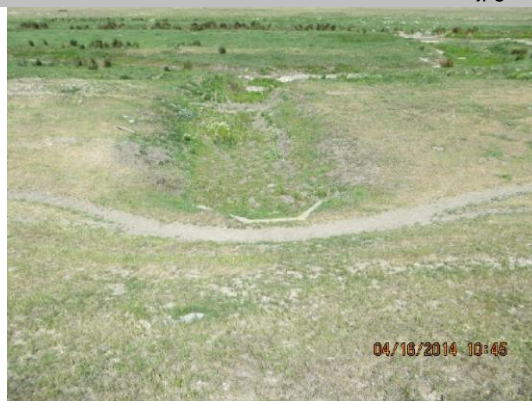
Photo 1 of 3 : UCIP\_SP\_2021\_62056\_61128.jpg

Pipe, flapgate, and headwall on WS toe.

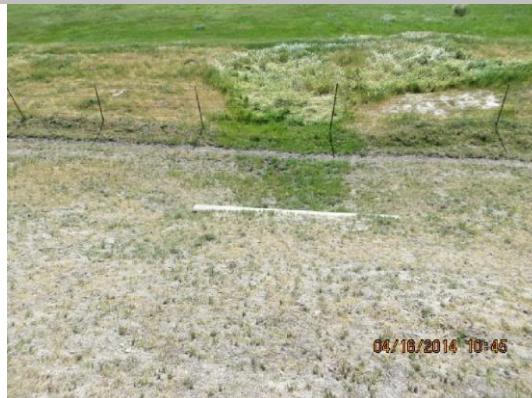
Photo 3 of 3 : UCIP\_SP\_2021\_62056\_61129.jpg

Pipe and headwall on LS toe.

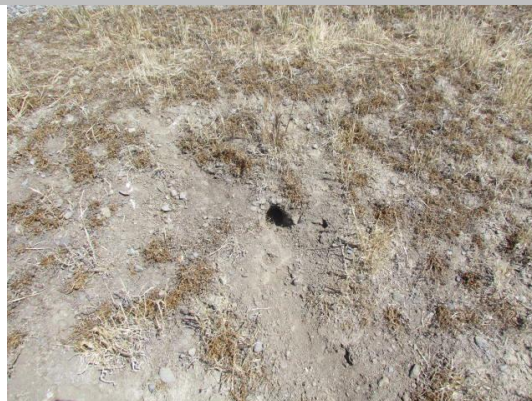
Photo 1 of 1 : SP\_2021\_NA0010\_126\_3\_20210308\_00001.jpg

LM Start	3.40	Rating **	A/W	Issue No.	3
LM End	3.54	Issue Type +	Ma	Location *	LS
Category	Earthen Levee			GPS Latitude/Longitude	
				Start	End
Item	Animal Control			37.253052 °	37.253600 °
				-120.722647 °	-120.720198 °
DWR ID	DWR_NA0010_08_s_2012_3				
Comment Code					
A3 : No rodents visible, but rodent burrows visible; need to backfill and compact or grout burrows.					
Inspector Comment					
Several rodent holes were noted on landside slope within this reach.

Looking at typical view of rodent holes on landward slope.

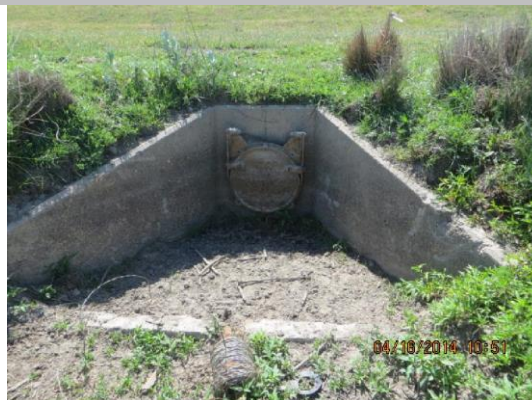
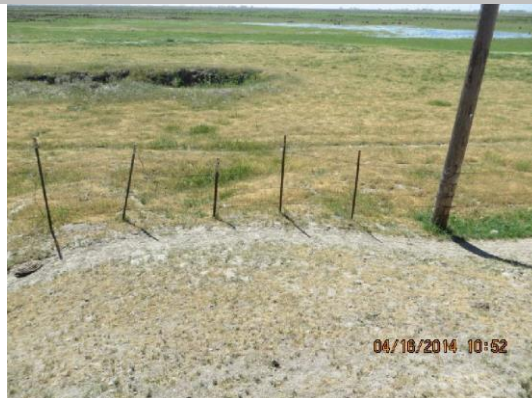
Comment Code					
Inspector Comment					
FS_ID:62057					
DS_ID:19840					
EP_NO: N/A					
Repair Type: Non-Urgent					
Crossing Status: Found					
UCIP Comments: 04/16/2014 No access available on landward side.					
Need to confirm status of crossing. (W. Wylie - DWR UCIP)					
FIELD_STRUCT_DESC: 24-inch corrugated metal gravity drainage					
pipe through the levee, 13 feet below the crown. Flap gate on the					
waterside (WS) end. Concrete headwall on each end. [Additional					
Reference(s): DWR Levee Log, 2002 (HLM 3.43), listed as a 24-inch					
corrugated metal pipe (CMP). USACE San Joaquin O&M Manual, Unit					
601 Part 1 (SJR601.1), 1967, (HLM 3.43), listed as a 24-inch CMP].					
FS Date: 4/16/2014

Pipe, headwall, and flapgate on WS toe.

Pipe likely at drainage swale off LS toe.

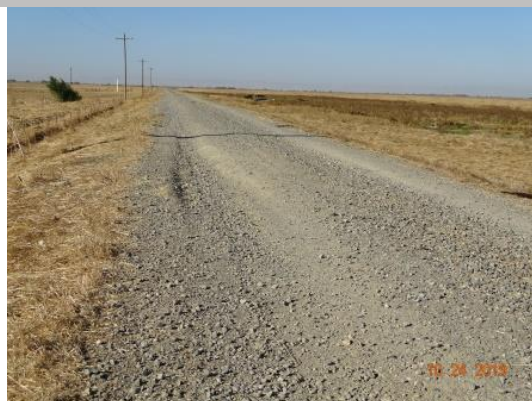
Photo 1 of 1 : SP\_2021\_NA0010\_126\_19\_20210308\_00004.jpg

LM Start	3.49	Rating **	M	Issue No.	19
LM End	3.49	Issue Type +	Ma	Location *	CR
Category	Earthen Levee			GPS Latitude/Longitude	
				Start	End
Item	Crown Surface / Depressions / Rutting			37.253403 °	37.253403 °
				-120.721095 °	-120.721095 °
DWR ID	DWR_NA0010_08_f_2018_19				
Comment Code					
C2 : Repair depressions or ruts in the crown or slope.					
Inspector Comment

View of ruts forming in the levee crown. (Fall 2019)

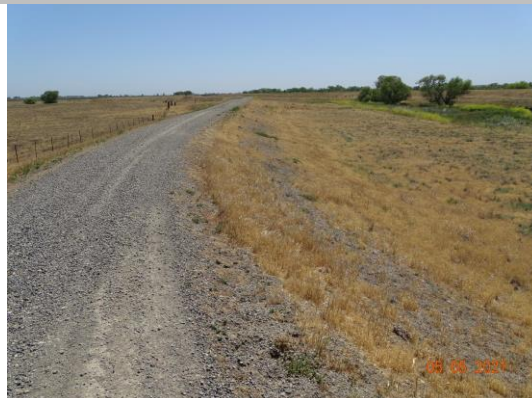
Photo 1 of 1 : SP\_2021\_NA0010\_127\_5\_20210518\_00011.jpg

LM Start	0.22	Rating **	A	Issue No.	5
LM End	0.22	Issue Type +	Ma	Location *	WS
Category	Earthen Levee			GPS Latitude/Longitude	
				Start	End
Item	Vegetation			37.219975 °	37.219975 °
				-120.709616 °	-120.709616 °
DWR ID	DWR_NA0010_09_s_2021_5				
Comment Code					
V1 : Control annual grass and weeds on the levee slopes and easements.					
Inspector Comment					
The annual vegetation is well maintained.

View of vegetation management on the waterside slope. (Spring 2021)

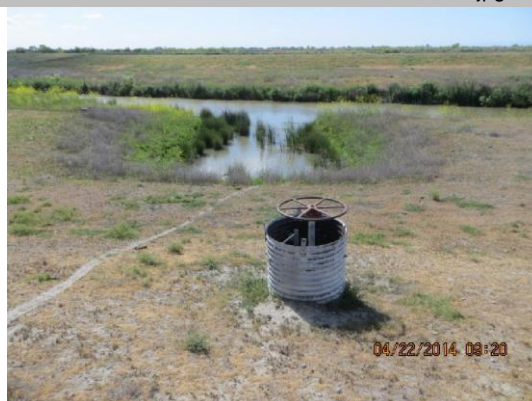
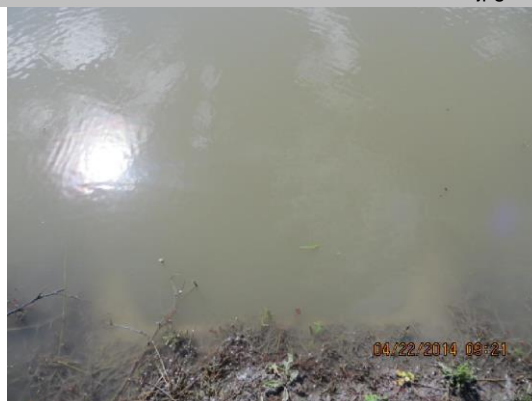
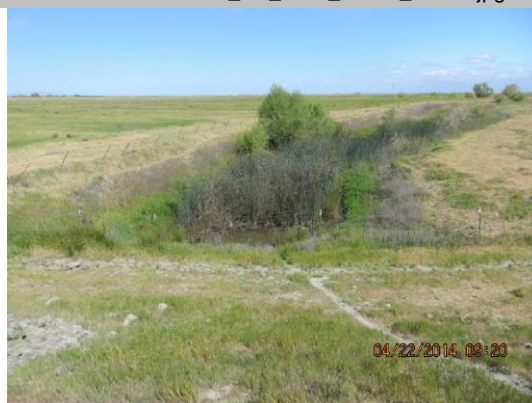
Comment Code						
Inspector Comment						
FS_ID:62059 DS_ID:19841 EP_NO: N/A Repair Type: Non-Urgent Crossing Status: Found UCIP Comments: 04/22/2014 Concrete headwalls on landward and waterward under water. Need photo to confirm condition of concrete headwalls, pipe, and gate on both toes. (W. Wylie - DWR UCIP) FIELD_STRUCT_DESC: 24-inch corrugated metal gravity drainage pipe through the levee, 18.7 feet below the crown. Slide gate in a 36-inch corrugated metal pipe (CMP) riser on the waterside (WS) slope. Concrete U-shaped headwall on each end. [Additional Reference(s): DWR Levee Log, 2002 (HLM 0.48), listed as a 24-inch corrugated metal pipe (CMP). USACE San Joaquin O&M Manual, Unit 601 Part 1 (SJR601.1), 1967, (HLM 0.47), listed as a 24-inch CMP]. FS Date: 4/22/2014

Slide gate in CMP riser on WS slope with outlet visible in background.

Concrete headwall visible under water on WS toe.

Concrete headwall visible at inlet on LS toe.

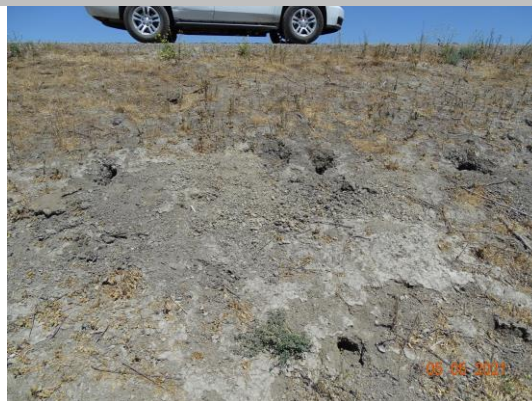
Photo 1 of 1 : SP\_2021\_NA0010\_127\_6\_20210518\_00012.jpg

LM Start	0.48	Rating **	M	Issue No.	6
LM End	0.48	Issue Type +	Ma	Location *	WS
Category	Earthen Levee			GPS Latitude/Longitude	
				Start	End
Item	Animal Control			37.220489 °	37.220489 °
				-120.705021 °	-120.705021 °
DWR ID	DWR_NA0010_09_s_2021_6				
Comment Code					
A1 : Exterminate rodents and backfill and compact or grout burrows.					
Inspector Comment

View of rodent burrows in the waterside slope. (Spring 2021)

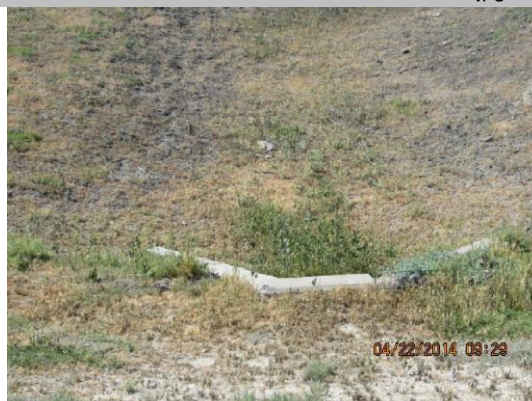
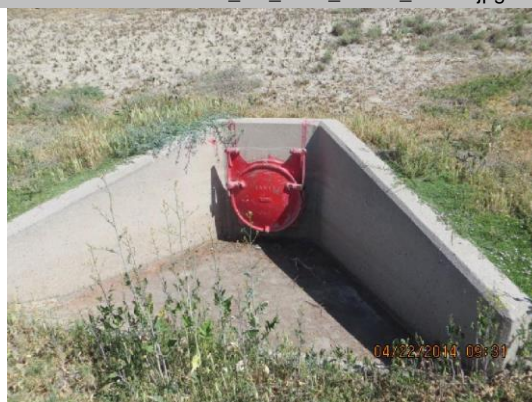
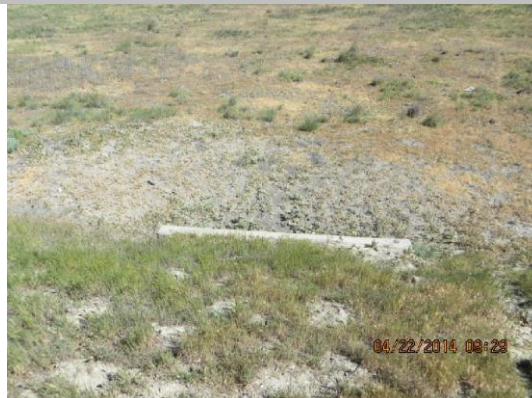
Comment Code						
Inspector Comment						
FS_ID:62060						
DS_ID:19842						
EP_NO: N/A						
Repair Type: Non-Urgent						
Crossing Status: Found						
UCIP Comments: 04/22/2014 Animal burrows in area on LS slope.						
Minor sediment buildup in pipe visible on landward side--recommend clearing. (W. Wylie - DWR UCIP)						
FIELD_STRUCT_DESC: 24-inch corrugated metal gravity drainage pipe through the levee, 8.7 feet below the crown. Flap gate on the waterside (WS) end. Concrete headwall on the landside (LS) end. Concrete U-shaped headwall on the WS end. [Additional Reference(s): DWR Levee Log, 2002 (HLM 0.70), listed as a 24-inch corrugated metal pipe (CMP). USACE San Joaquin O&M Manual, Unit 601 Part 1 (SJR601.1), 1967, (HLM 0.70), listed as a 24-inch CMP].						
FS Date: 4/22/2014

Headwall, flapgate, and pipe on WS toe.

Headwall and pipe on LS toe.

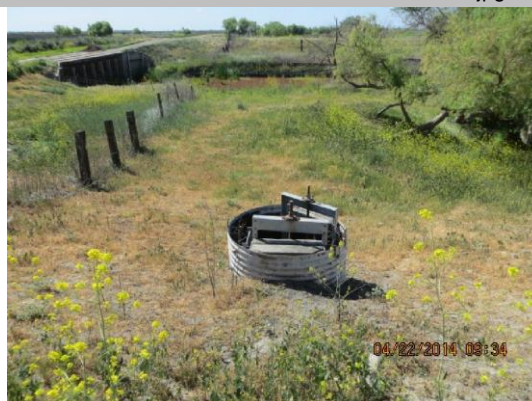
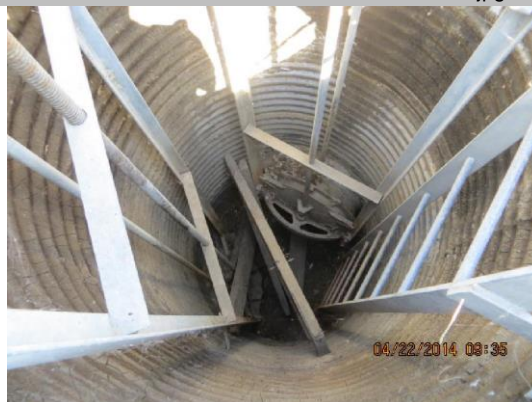
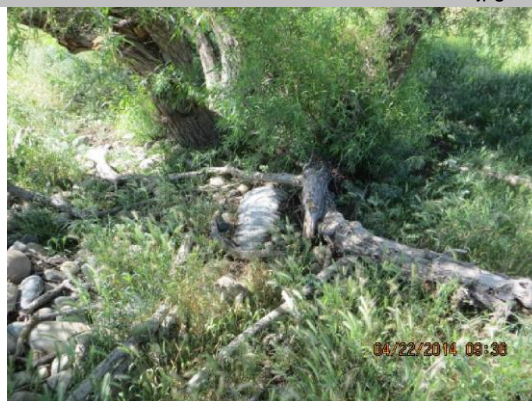
Comment Code						
Inspector Comment						
FS_ID:62061						
DS_ID:19843						
EP_NO: N/A						
Repair Type: No Action Needed						
Crossing Status: Found						
UCIP Comments:						
FIELD_STRUCT_DESC: [Crane Irrigation Structure] 24-inch corrugated metal gravity drainage pipe through the levee, 9.7 feet below the crown. Two slide gates in a 48-inch corrugated metal pipe (CMP) riser on the waterside (WS) slope. Concrete U-shaped headwall on the landside (LS) end. WS end cobble revetted on the bank and in the outlet drain. [Additional Reference(s): DWR Levee Log, 2002 (HLM 0.87), listed as a 24-inch corrugated metal pipe (CMP). USACE San Joaquin O&M Manual, Unit 601 Part 1 (SJR601.1), 1967, (HLM 0.87), listed as a 24-inch CMP].						
FS Date: 4/22/2014

48-inch CMP riser with slide gates on WS slope.

Inside CMP riser on WS slope.

Outlet at WS toe.

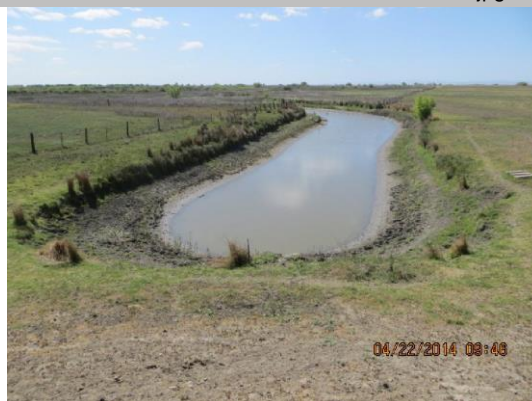
Comment Code						
Inspector Comment						
FS_ID:62062 DS_ID:19845 EP_NO: N/A Repair Type: Non-Urgent Crossing Status: Found UCIP Comments: 04/22/2014 Inlet blocked at LS toe by wooden gate. Need to contact owner to determine status. (W. Wylie - DWR UCIP) FIELD_STRUCT_DESC: 36-inch corrugated metal gravity drainage pipe through the levee, 19.6 feet below the crown. Slide gate in a 48- inch corrugated metal pipe (CMP) riser on the waterside (WS) slope. Concrete U-shaped headwall on each end. [Additional Reference(s): DWR Levee Log, 2002 (HLM 0.31), listed as a 24-inch corrugated metal pipe (CMP). USACE San Joaquin O&M Manual, Unit 601 Part 1 (SJR601.1), 1967, (HLM 0.31), listed as a 24-inch CMP]. FS Date: 4/22/2014

Headwall and pipe visible on LS toe. Slide gate inside 48-inch CMP riser on WS slope.

Headwall and pipe on WS toe.

Headwall and pipe on LS toe. Pipe blocked by wooden cover.

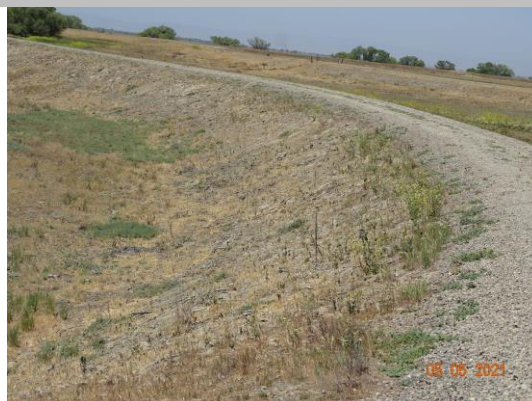
Photo 1 of 1 : SP\_2021\_NA0010\_128\_2\_20210518\_00004.jpg

LM Start	0.46	Rating **	A	Issue No.	2
LM End	0.46	Issue Type +	Ma	Location *	LS
Category	Earthen Levee			GPS Latitude/Longitude	
				Start	End
Item	Vegetation			37.219613 °	37.219613 °
				-120.703765 °	-120.703765 °
DWR ID	DWR_NA0010_10_s_2021_2				
Comment Code					
V1 : Control annual grass and weeds on the levee slopes and easements.					
Inspector Comment					
The annual vegetation is well maintained.

View of vegetation management on the landside slope. (Spring 2021)
