**Flood Control Project Maintenance  
Levee Inspections**

## Maintenance Issue Types Only, Levee Inspection Report By Mile - Spring 2021

### Lower San Joaquin Levee District

Waterway	Bank	Unit Miles	Inspection Start/End	Inspector
Unit No. 01 San Joaquin River	Right	22.52	05/04/2021 05/04/2021	Corey Fujitani

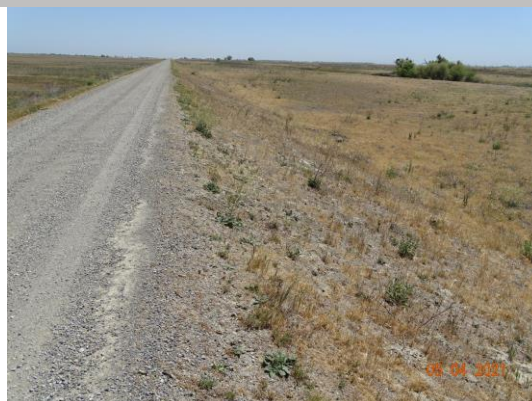
Photo 1 of 1 : SP\_2021\_NA0010\_129\_14\_20210518\_00030.jpg

LM Start	0.02	Rating **	A	Issue No.	14
LM End	0.02	Issue Type +	Ma	Location *	WS
Category	Earthen Levee			GPS Latitude/Longitude	
				Start	End
Item	Vegetation			37.202739 °	37.202739 °
				-120.754827 °	-120.754827 °
DWR ID	DWR_NA0010_11_s_2021_14				
Comment Code					
V1 : Control annual grass and weeds on the levee slopes and easements.					
Inspector Comment					
The annual vegetation is well maintained.

Looking upstream along the waterside slope. (Spring 2021)

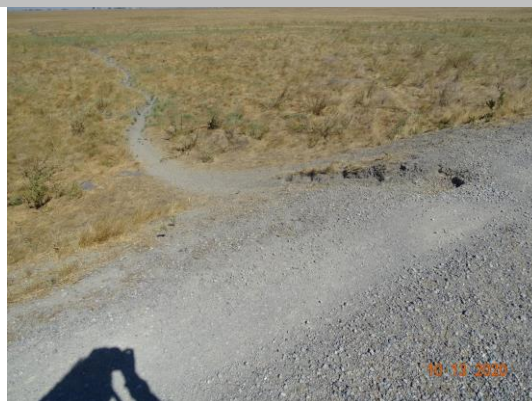
Photo 1 of 1 : SP\_2021\_NA0010\_129\_10\_20210308\_00002.jpg

LM Start	0.16	Rating **	A/W	Issue No.	10
LM End	0.16	Issue Type +	Ma	Location *	LS
Category	Earthen Levee			GPS Latitude/Longitude	
				Start	End
Item	Animal Control			37.202730 °	37.202730 °
				-120.752270 °	-120.752270 °
DWR ID	DWR_NA0010_11_f_2018_10				
Comment Code					
A2 : Repair the levee slope damaged by livestock and prevent large animal access.					
Inspector Comment					
Material has been placed on levee damage. Monitor for settlement.

View of livestock damage to the landside slope. (Fall 2020)

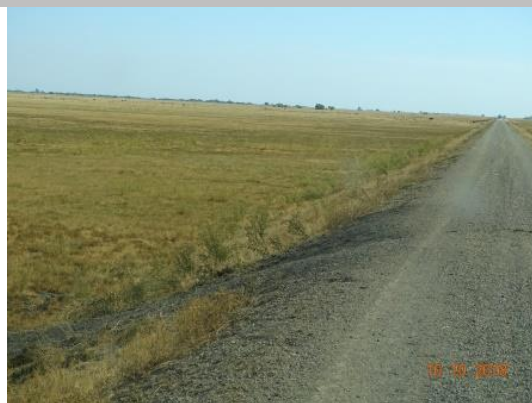
Photo 1 of 1 : SP\_2021\_NA0010\_129\_11\_20210308\_00003.jpg

LM Start	0.21	Rating **	A/W	Issue No.	11
LM End	0.21	Issue Type +	Ma	Location *	LS
Category	Earthen Levee			GPS Latitude/Longitude	
				Start	End
Item	Animal Control			37.202731 °	37.202731 °
				-120.751389 °	-120.751389 °
DWR ID	DWR_NA0010_11_f_2018_11				
Comment Code					
A2 : Repair the levee slope damaged by livestock and prevent large animal access.					
Inspector Comment					
Material has been placed on levee damage. Monitor for settlement.

View of slope damage on landside. (Fall 2018)

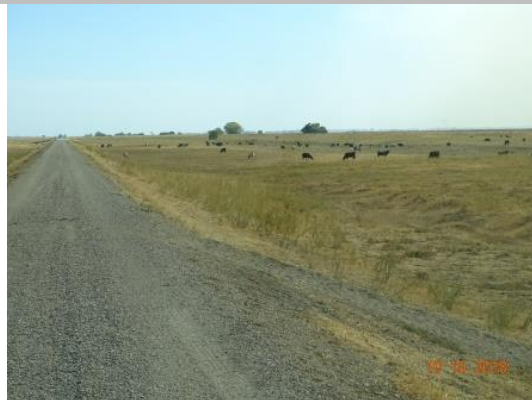
Photo 1 of 1 : SP\_2021\_NA0010\_129\_13\_20210308\_00006.jpg

LM Start	0.21	Rating **	A/W	Issue No.	13
LM End	0.21	Issue Type +	Ma	Location *	WS
Category	Earthen Levee			GPS Latitude/Longitude	
				Start	End
Item	Animal Control			37.202731 °	37.202731 °
				-120.751389 °	-120.751389 °
DWR ID	DWR_NA0010_11_s_2020_13				
Comment Code					
A2 : Repair the levee slope damaged by livestock and prevent large animal access.					
Inspector Comment					
Material has been placed on levee damage. Monitor for settlement.

View of damage on waterside shoulder and slope. (Fall 2018)

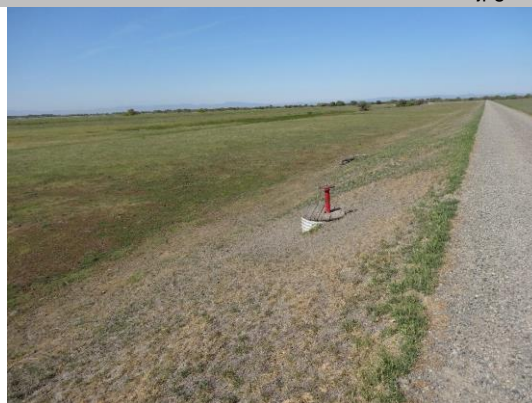
Photo 1 of 3 : UCIP\_SP\_2021\_62063\_66644.jpg

Comment Code						
Inspector Comment						
FS_ID:62063 DS_ID:19846 EP_NO: N/A Repair Type: Non-Urgent Crossing Status: Found UCIP Comments: 04/18/2014 Need to contact owner. Recommend clearing sediment deposit inside pipe. (O. Magana - DWR UCIP) FIELD_STRUCT_DESC: 24-inch corrugated metal gravity drainage pipe through the levee, 11 feet below the crown. Slide gate in a corrugated metal pipe (CMP) riser on the waterside (WS) end. [Additional Reference(s): DWR Levee Log, 2002 (HLM 0.43), listed as a 24-inch corrugated metal pipe (CMP). USACE San Joaquin O&M Manual, Unit 601 Part 1 (SJR601.1), 1967, (HLM 0.42), listed as a 24-inch CMP]. FS Date: 4/18/2014

View of slide gate inside CMP riser located on waterward slope.

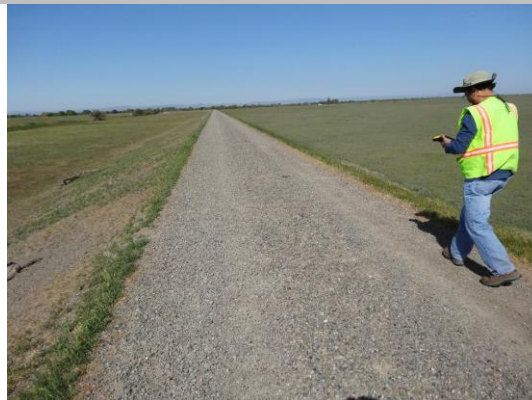
Photo 2 of 3 : UCIP\_SP\_2021\_62063\_66643.jpg

View of levee crown at crossing.

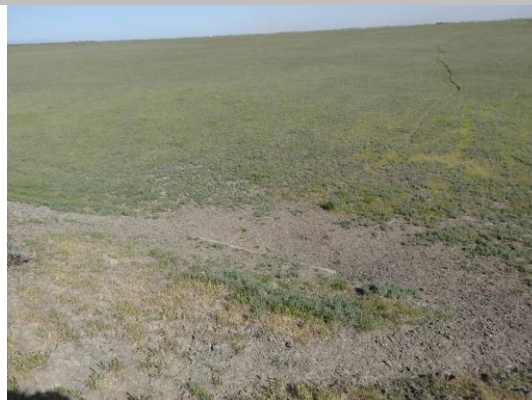
Photo 3 of 3 : UCIP\_SP\_2021\_62063\_66642.jpg

View of landward side.

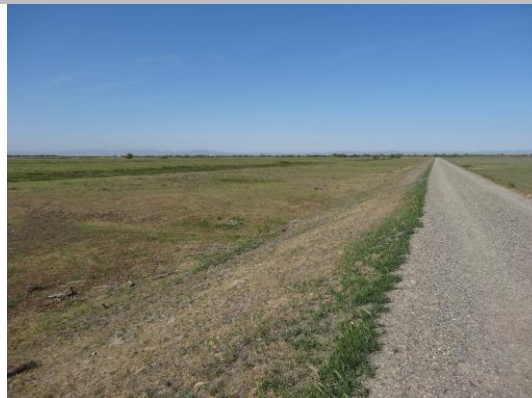
Photo 1 of 3 : UCIP\_SP\_2021\_62064\_61997.jpg

LM Start	0.65	Rating **	M	Issue No.	3	
LM End	0.65	Issue Type +	Ma	Location *		
Category	Supplemental			GPS Latitude/Longitude		
				Start		End
Item	DWR UCIP LMA Responsibility			37.202751 °		37.202751 °
				-120.743474 °		-120.743474 °
DWR ID	19847					
Comment Code						
Inspector Comment						
FS_ID:62064 DS_ID:19847 EP_NO: N/A Repair Type: Non-Urgent Crossing Status: Found UCIP Comments: 04/18/2014 Need to contact owner. Recommend clearing sediment deposit inside pipe. (O. Magana - DWR UCIP) FIELD_STRUCT_DESC: 24-inch corrugated metal gravity drainage pipe through the levee, 10 feet below the crown. Flap gate on the waterside (WS) end. [Additional Reference(s): DWR Levee Log, 2002 (HLM 0.65), listed as a 24-inch corrugated metal pipe (CMP). USACE San Joaquin O&M Manual, Unit 601 Part 1 (SJR601.1), 1967, (HLM 0.65), listed as a 24-inch CMP]. FS Date: 4/18/2014

View of waterward side.

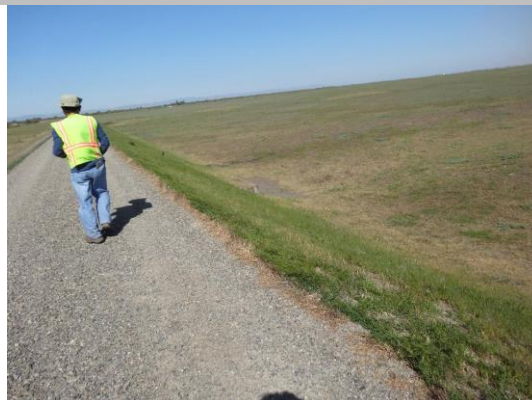
Photo 2 of 3 : UCIP\_SP\_2021\_62064\_61996.jpg

View of landward side.

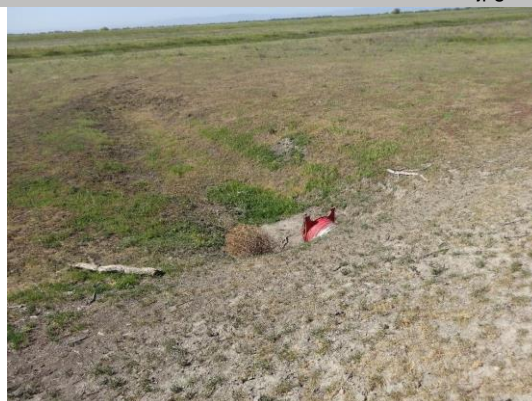
Photo 3 of 3 : UCIP\_SP\_2021\_62064\_61999.jpg

Flap gate and concrete apron located on waterward side.

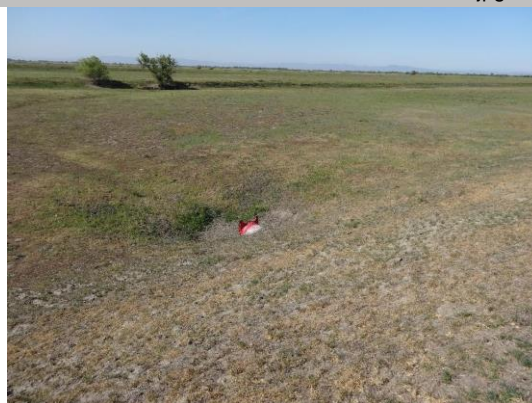
Photo 1 of 3 : UCIP\_SP\_2021\_62065\_62003.jpg

FS\_ID:62065  
DS\_ID:19848  
EP\_NO: N/A  
Repair Type: Non-Urgent  
Crossing Status: Found  
UCIP Comments: 04/18/2014 Need to contact owner. Recommend clearing sediment deposit inside pipe. (O. Magana - DWR UCIP)  
FIELD\_STRUCT\_DESC: 24-inch corrugated metal gravity drainage pipe through the levee, 10.3 feet below the crown. Flap gate on the waterside (WS) end. [Additional Reference(s): DWR Levee Log, 2002 (HLM 0.85), listed as a 24-inch corrugated metal pipe (CMP). USACE San Joaquin O&M Manual, Unit 601 Part 1 (SJR601.1), 1967, (HLM 0.84), listed as a 24-inch CMP].  
FS Date: 4/18/2014

Overview of waterward side.

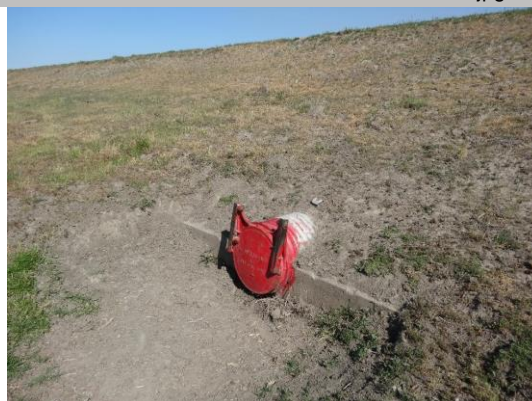
Photo 2 of 3 : UCIP\_SP\_2021\_62065\_62002.jpg

Concrete headwall and flap gate visible on waterward side.

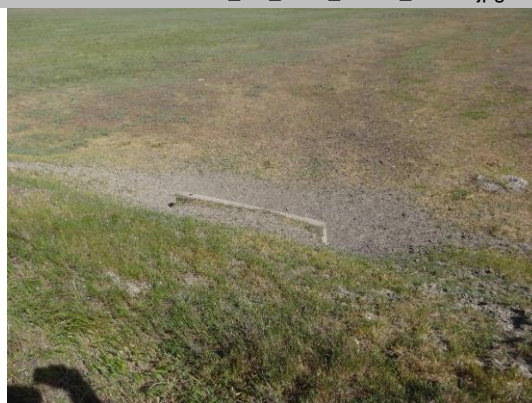
Photo 3 of 3 : UCIP\_SP\_2021\_62065\_62001.jpg

View of landward side.

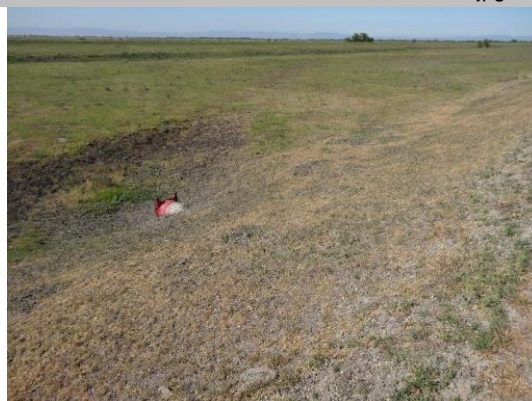
Photo 1 of 3 : UCIP\_SP\_2021\_62066\_62008.jpg

Comment Code						
Inspector Comment						
FS_ID:62066						
DS_ID:19849						
EP_NO: N/A						
Repair Type: Non-Urgent						
Crossing Status: Found						
UCIP Comments: 04/18/2014 Need to contact owner. Recommend clearing sediment deposit inside pipe. (O. Magana - DWR UCIP)						
FIELD_STRUCT_DESC: 24-inch corrugated metal gravity drainage pipe through the levee, 9 feet below the crown. Flap gate on the waterside (WS) end. [Additional Reference(s): DWR Levee Log, 2002 (HLM 1.13), listed as a 24-inch corrugated metal pipe (CMP). USACE San Joaquin O&M Manual, Unit 601 Part 1 (SJR601.1), 1967, (HLM 1.13), listed as a 24-inch CMP].						
FS Date: 4/18/2014

View of waterward side--flap gate visible at levee toe.

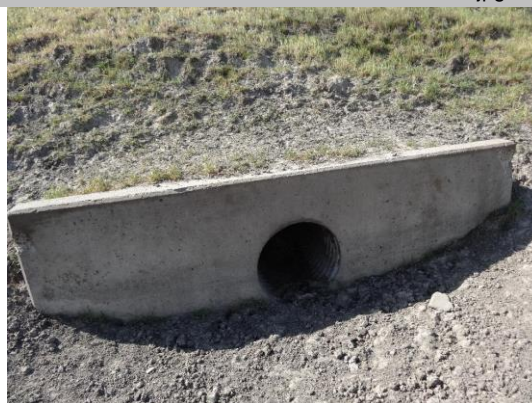
Photo 3 of 3 : UCIP\_SP\_2021\_62066\_62006.jpg

Concrete headwall located on landward side.

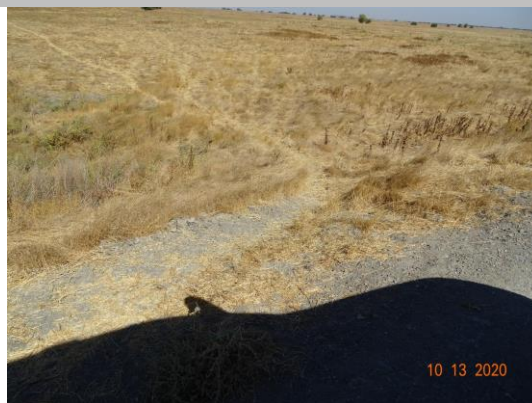
Photo 1 of 1 : SP\_2021\_NA0010\_129\_9\_20210308\_00001.jpg

LM Start	1.49	Rating **	A/W	Issue No.	9
LM End	1.49	Issue Type +	Ma	Location *	LS
Category	Earthen Levee			GPS Latitude/Longitude	
				Start	End
Item	Animal Control			37.202748 °	37.202748 °
				-120.728182 °	-120.728182 °
DWR ID	DWR_NA0010_11_f_2017_9				
Comment Code					
A2 : Repair the levee slope damaged by livestock and prevent large animal access.					
Inspector Comment

View of livestock trail on the landside slope. (Fall 2020)

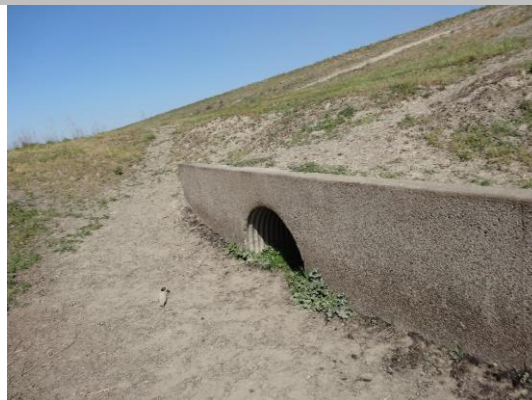
Photo 2 of 3 : UCIP\_SP\_2021\_62067\_62017.jpg

View of concrete headwall located on waterward side.

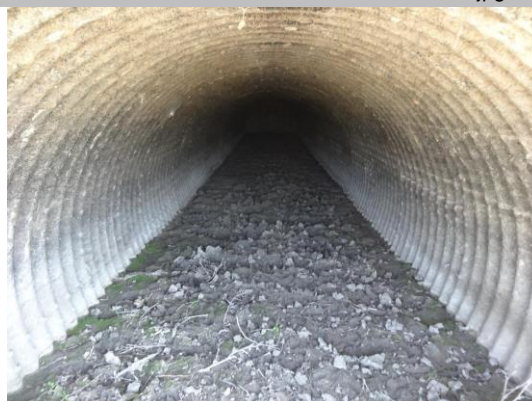
Photo 3 of 3 : UCIP\_SP\_2021\_62067\_62016.jpg

Inside view of pipe from waterward side--sediment build up.

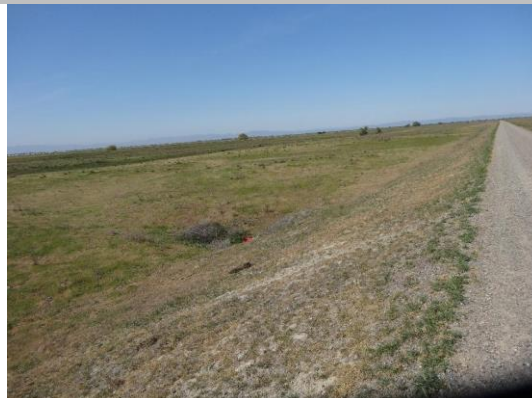
Photo 1 of 3 : UCIP\_SP\_2021\_62068\_62024.jpg

LM Start	1.98	Rating **	M	Issue No.	7	
LM End	1.98	Issue Type +	Ma	Location *		
Category	Supplemental			GPS Latitude/Longitude		
				Start		End
Item	DWR UCIP LMA Responsibility			37.202740 °		37.202740 °
				-120.719247 °		-120.719247 °
DWR ID	19851					
Comment Code						
Inspector Comment						
FS_ID:62068 DS_ID:19851 EP_NO: N/A Repair Type: Non-Urgent Crossing Status: Found UCIP Comments: 04/18/2014 Need to contact owner. Recommend clearing sediment deposit inside pipe. (O. Magana - DWR UCIP) FIELD_STRUCT_DESC: 24-inch corrugated metal gravity drainage pipe through the levee, 12.8 feet below the crown. Flap gate on the waterside (WS) end. [Additional Reference(s): DWR Levee Log, 2002 (HLM 1.99), listed as a 24-inch corrugated metal pipe (CMP). USACE San Joaquin O&M Manual, Unit 601 Part 1 (SJR601.1), 1967, (HLM 1.99), listed as a 24-inch CMP]. FS Date: 4/18/2014

View of waterward side.

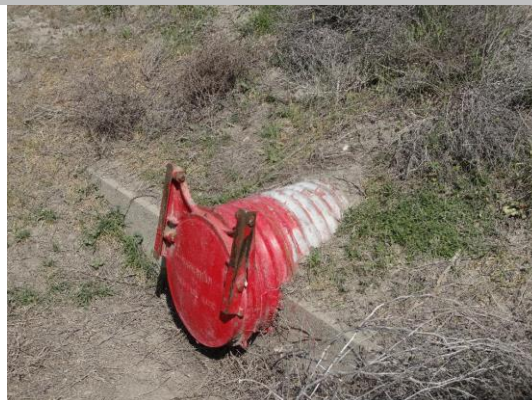
Photo 2 of 3 : UCIP\_SP\_2021\_62068\_62025.jpg

Flap gate located on waterward side.

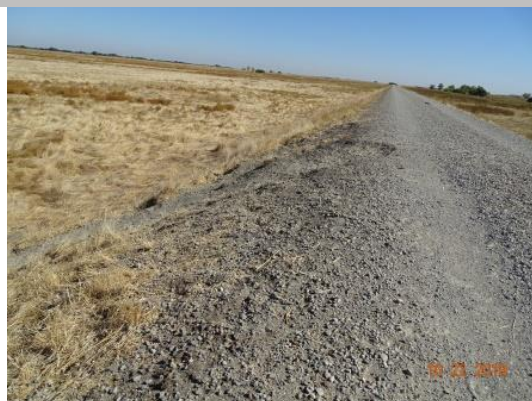
Photo 1 of 1 : SP\_2021\_NA0010\_129\_17\_20210308\_00008.jpg

LM Start	2.31	Rating **	M	Issue No.	17
LM End	2.31	Issue Type +	Ma	Location *	LS
Category	Earthen Levee			GPS Latitude/Longitude	
				Start	End
Item	Animal Control			37.202730 °	37.202730 °
				-120.713368 °	-120.713368 °
DWR ID	DWR_NA0010_11_f_2019_17				
Comment Code					
A2 : Repair the levee slope damaged by livestock and prevent large animal access.					
Inspector Comment

Damage to the landside slope from livestock traffic. (Fall 2019)

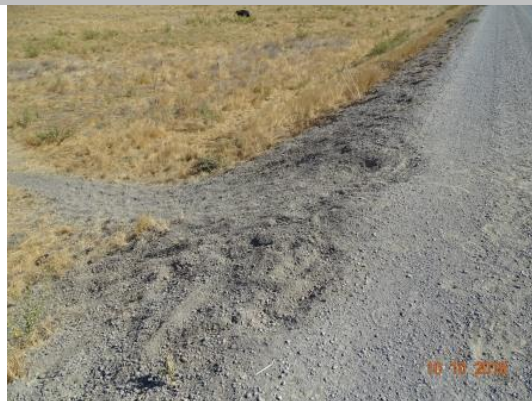
Photo 1 of 2 : SP\_2021\_NA0010\_129\_12\_20210308\_00004.jpg

LM Start	2.46	Rating **	A/W	Issue No.	12
LM End	2.46	Issue Type +	Ma	Location *	LS
Category	Earthen Levee			GPS Latitude/Longitude	
				Start	End
Item	Animal Control			37.202712 °	37.202712 °
				-120.710633 °	-120.710633 °
DWR ID	DWR_NA0010_11_f_2018_12				
Comment Code					
A2 : Repair the levee slope damaged by livestock and prevent large animal access.					
Inspector Comment					
Damage is from livestock to both landside and waterside slopes.

View of landside slope. (Fall 2018)

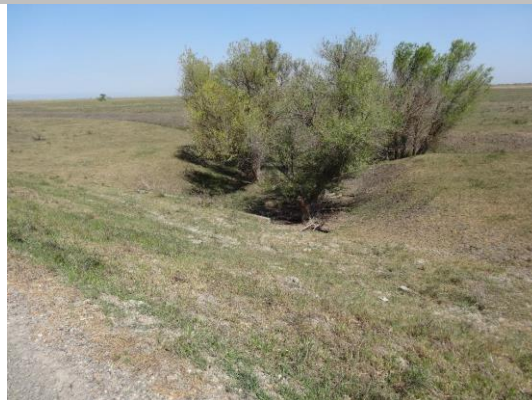
Photo 2 of 3 : UCIP\_SP\_2021\_62069\_62027.jpg

View of landward side.

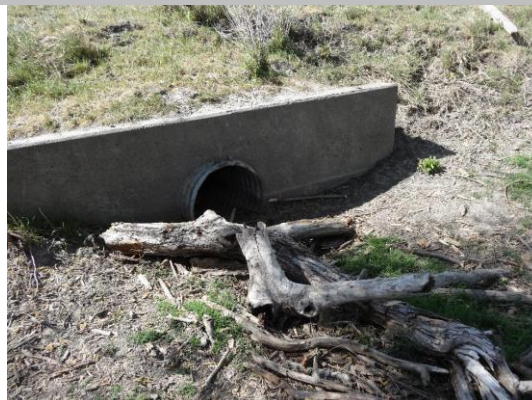
Photo 3 of 3 : UCIP\_SP\_2021\_62069\_62030.jpg

Concrete headwall located on landward side--debris in front of headwall.

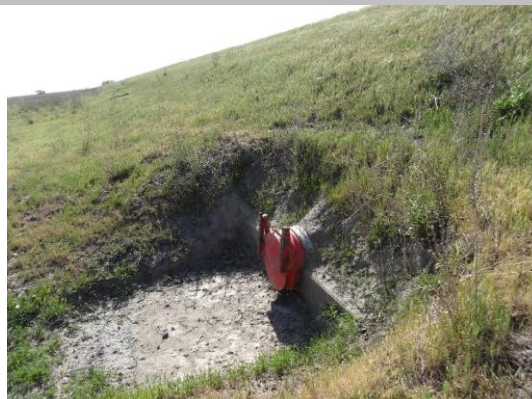
Photo 2 of 3 : UCIP\_SP\_2021\_62072\_66649.jpg

Comment Code						
Inspector Comment						
FS_ID:62072						
DS_ID:19855						
EP_NO: N/A						
Repair Type: Non-Urgent						
Crossing Status: Found						
UCIP Comments: 04/18/2014 Need to contact owner. Dense vegetation limits the inspector's visibility to identify signs of pipe failure (leaks) along the waterward slope. Recommend removing vegetation along pipe alignment to conduct proper inspection of structure. (O. Magana - DWR UCIP)						
FIELD_STRUCT_DESC: 24-inch corrugated metal gravity drainage pipe through the levee, 10.5 feet below the crown. Flap gate on the waterside (WS) end. [Additional Reference(s): DWR Levee Log, 2002 (HLM 0.41), listed as a 24-inch corrugated metal pipe (CMP). USACE San Joaquin O&M Manual, Unit 601 Part 1 (SJR601.1), 1967, (HLM 0.39), listed as a 24-inch CMP].						
FS Date: 4/18/2014

Concrete headwall and flap gate visible on waterward side.

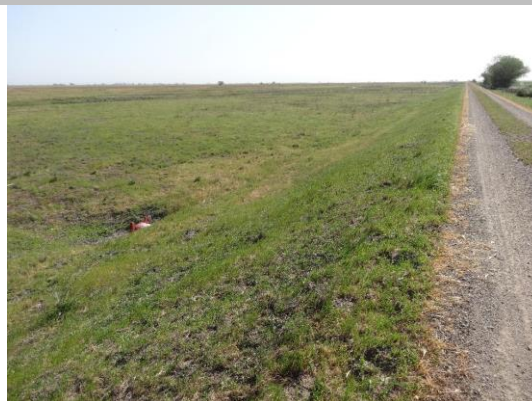
Photo 1 of 3 : UCIP\_SP\_2021\_62073\_62048.jpg

FS\_ID:62073  
 DS\_ID:19856  
 EP\_NO: N/A  
 Repair Type: Non-Urgent  
 Crossing Status: Found  
 UCIP Comments: 04/18/2014 Need to contact owner. Recommend clearing sediment deposit inside pipe. (O. Magana - DWR UCIP)  
 FIELD\_STRUCT\_DESC: 24-inch corrugated metal gravity drainage pipe through the levee, 10.5 feet below the crown. Flap gate on the waterside (WS) end. [Additional Reference(s): DWR Levee Log, 2002 (HLM 1.06), listed as a 24-inch corrugated metal pipe (CMP). USACE San Joaquin O&M Manual, Unit 601 Part 1 (SJR601.1), 1967, (HLM 1.06), listed as a 24-inch CMP].  
 FS Date: 4/18/2014

View of waterward side.

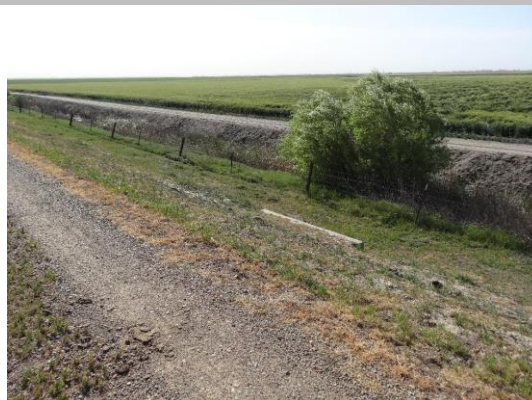
Photo 3 of 3 : UCIP\_SP\_2021\_62073\_62047.jpg

View of landward side.

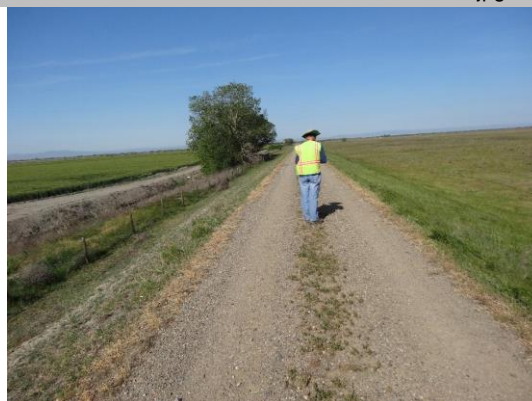
Photo 1 of 3 : UCIP\_SP\_2021\_62074\_66654.jpg

Comment Code						
Inspector Comment						
FS_ID:62074						
DS_ID:19857						
EP_NO: N/A						
Repair Type: Non-Urgent						
Crossing Status: Found						
UCIP Comments: 04/18/2014 Landward side not accessible due to dense vegetation and fence. Concrete headwall and flap gate under water therefore not able to evaluate condition. Will need to coordinate with owner to evaluate condition of crossing on waterward side and obtain access to evaluate landward side. (O. Magana - DWR UCIP)						
FIELD_STRUCT_DESC: 24-inch corrugated metal gravity drainage pipe through the levee, 17.4 feet below the crown. Flap gate on the waterside (WS) end. [Additional Reference(s): DWR Levee Log, 2002 (HLM 1.28), listed as a 24-inch corrugated metal pipe (CMP). USACE San Joaquin O&M Manual, Unit 601 Part 1 (SJR601.1), 1967, (HLM 1.27), listed as a 24-inch CMP].						
FS Date: 4/18/2014

Overview of levee crown at crossing.

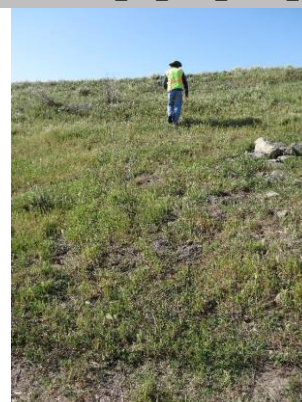
Photo 2 of 3 : UCIP\_SP\_2021\_62074\_66652.jpg

View of waterward slope.

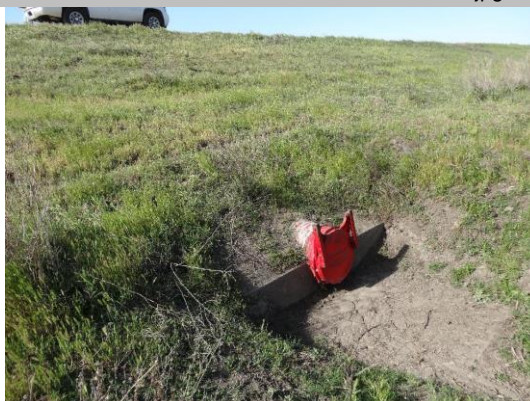
Photo 2 of 3 : UCIP\_SP\_2021\_62075\_62061.jpg

Concrete headwall and flap gate visible on waterward side.

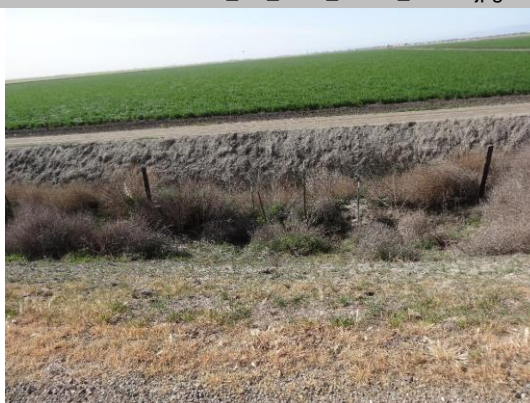
Photo 3 of 3 : UCIP\_SP\_2021\_62075\_62059.jpg

View of landward side--limited access due to fence.

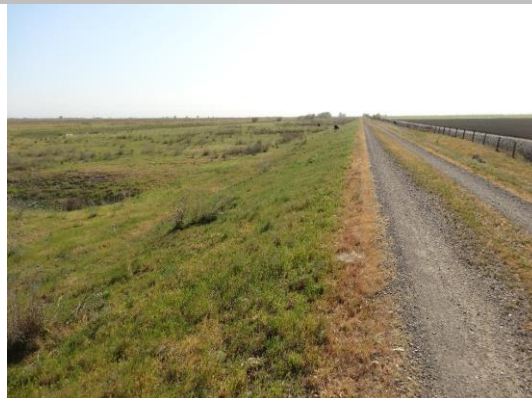
Photo 1 of 3 : UCIP\_SP\_2021\_62076\_62064.jpg

Comment Code						
Inspector Comment						
FS_ID:62076 DS_ID:19859 EP_NO: N/A Repair Type: Non-Urgent Crossing Status: Found UCIP Comments: 04/18/2014 Need to contact owner. Recommend clearing vegetation from landward side--headwall blocked. (O. Magana - DWR UCIP) FIELD_STRUCT_DESC: 24-inch corrugated metal gravity drainage pipe through the levee, 14.4 feet below the crown. Flap gate on the waterside (WS) end. [Additional Reference(s): DWR Levee Log, 2002 (HLM 2.16), listed as a 24-inch corrugated metal pipe (CMP). USACE San Joaquin O&M Manual, Unit 601 Part 1 (SJR601.1), 1967, (HLM 2.16), listed as a 24-inch CMP]. FS Date: 4/18/2014

View of waterward side.

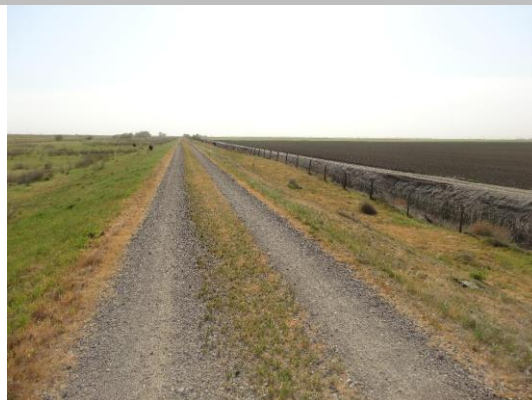
Photo 2 of 3 : UCIP\_SP\_2021\_62076\_62063.jpg

Overview of levee crown at crossing.

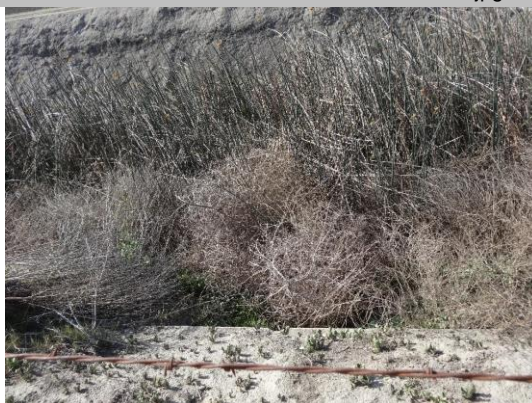
Photo 3 of 3 : UCIP\_SP\_2021\_62076\_62062.jpg

Dense vegetation on landward side--limited access due to fence along landward side.

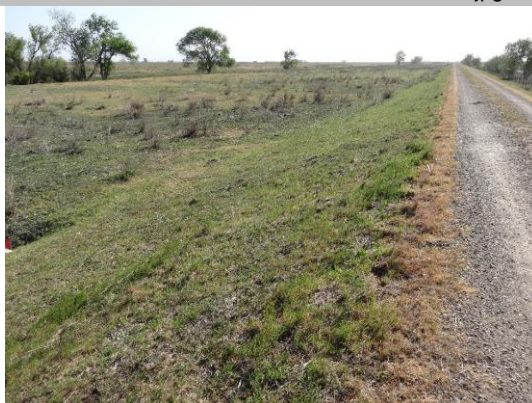
Photo 1 of 3 : UCIP\_SP\_2021\_62077\_62069.jpg

FS\_ID:62077  
 DS\_ID:19860  
 EP\_NO: N/A  
 Repair Type: Non-Urgent  
 Crossing Status: Found  
 UCIP Comments: 04/18/2014 Need to contact owner. Recommend clearing sediment deposit inside pipe. (O. Magana - DWR UCIP)  
 FIELD\_STRUCT\_DESC: 24-inch corrugated metal gravity drainage pipe through the levee, 10.7 feet below the crown. Flap gate on the waterside (WS) end. [Additional Reference(s): DWR Levee Log, 2002 (HLM 2.70), listed as a 24-inch corrugated metal pipe (CMP). USACE San Joaquin O&M Manual, Unit 601 Part 1 (SJR601.1), 1967, (HLM 2.70), listed as a 24-inch CMP].  
 FS Date: 4/18/2014

View of waterward side.

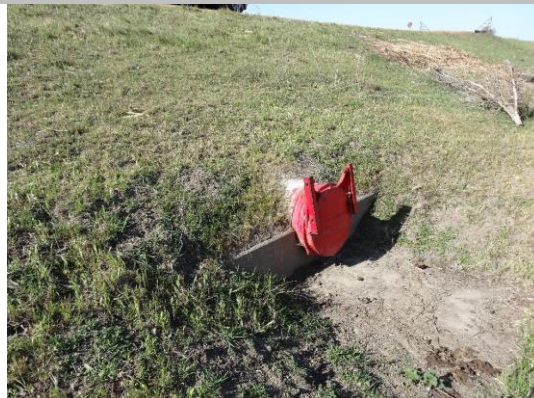
Photo 2 of 3 : UCIP\_SP\_2021\_62077\_62070.jpg

Concrete headwall and flat gate located on waterward side.

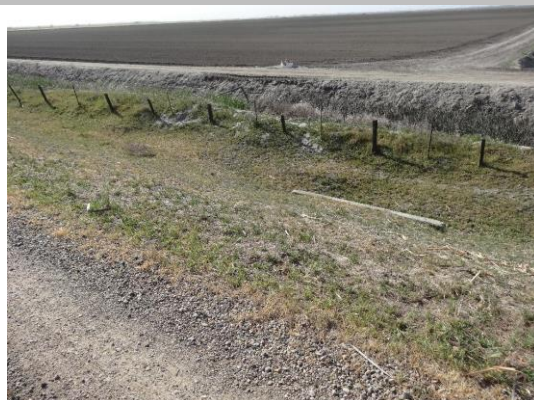
Photo 3 of 3 : UCIP\_SP\_2021\_62077\_62068.jpg

View of landward side.

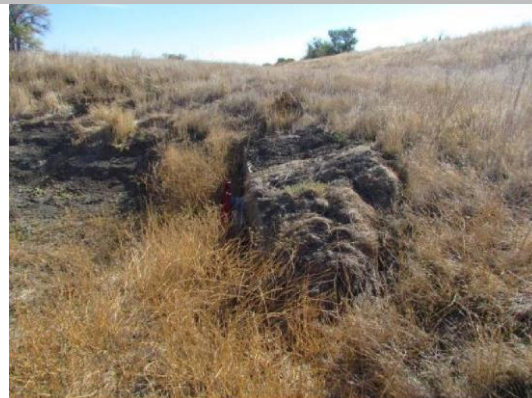
Photo 2 of 3 : UCIP\_SP\_2021\_62078\_74729.jpg

Repair to headwall located on waterward side has been addressed.

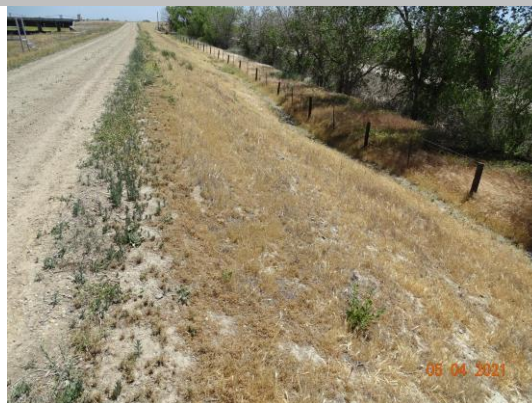
Photo 1 of 1 : SP\_2021\_NA0010\_130\_9\_20210518\_00022.jpg

LM Start	3.22	Rating **	A	Issue No.	9
LM End	3.22	Issue Type +	Ma	Location *	LS
Category	Earthen Levee			GPS Latitude/Longitude	
				Start	End
Item	Vegetation			37.200920 °	37.200920 °
				-120.696803 °	-120.696803 °
DWR ID	DWR_NA0010_12_s_2021_9				
Comment Code					
V1 : Control annual grass and weeds on the levee slopes and easements.					
Inspector Comment					
The annual vegetation is well maintained.

View of vegetation management on the landside slope. (Spring 2021)

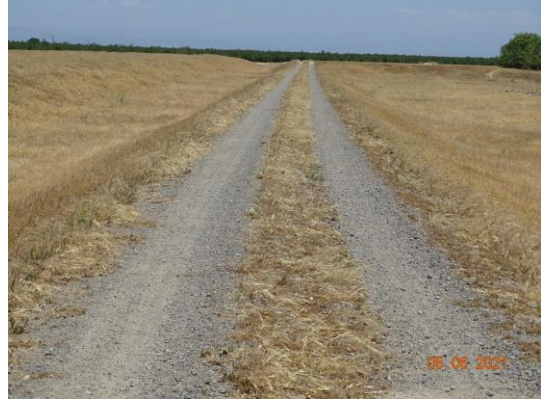
Photo 1 of 1 : SP\_2021\_NA0010\_131\_3\_20210518\_00010.jpg

LM Start	0.56	Rating **	M	Issue No.	3
LM End	0.91	Issue Type +	Ma	Location *	CR
Category	Earthen Levee			GPS Latitude/Longitude	
				Start	End
Item	Vegetation			37.041294 °	37.044851 °
				-120.438570 °	-120.434095 °
DWR ID	DWR_NA0010_13_s_2021_3				
Comment Code					
V9 : Keep the crown roadway free of vegetation.					
Inspector Comment

Looking upstream along the levee crown. (Spring 2021)

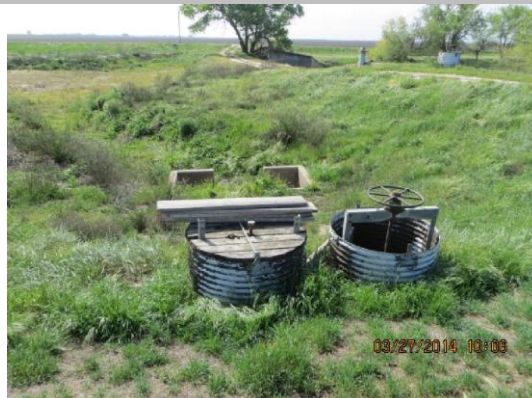
Photo 1 of 3 : UCIP\_SP\_2021\_62080\_59385.jpg

UCIP Comments: 03/27/2014 Appears abandoned and if so should be done so properly. Pipe filled with soil on WS at outlet. Actuator missing from slide gate on WS shoulder. (W. Wylie - DWR UCIP)

Slide gate in CMP riser on WS shoulder.

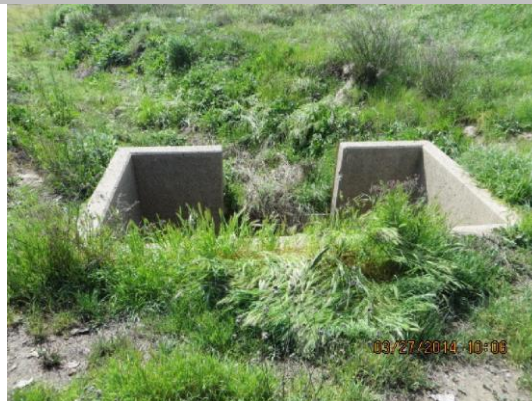
Photo 2 of 3 : UCIP\_SP\_2021\_62080\_59384.jpg

Concrete box on WS toe.

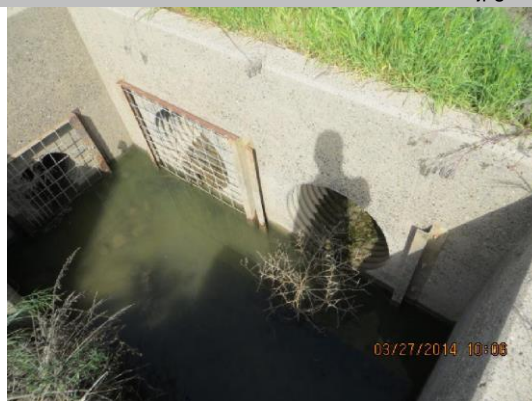
Photo 3 of 3 : UCIP\_SP\_2021\_62080\_59389.jpg

Concrete box on WS toe.

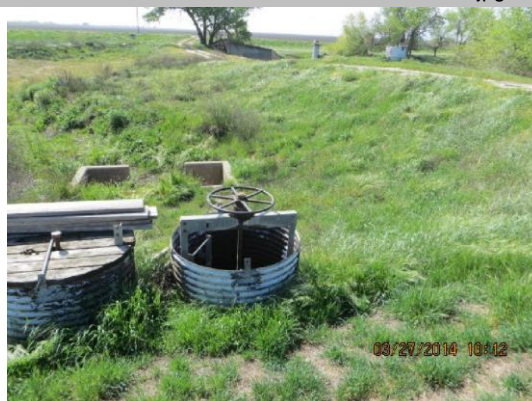
Photo 1 of 3 : UCIP\_SP\_2021\_62081\_59390.jpg

FS\_ID:62081  
DS\_ID:19908  
EP\_NO: N/A  
Repair Type: Non-Urgent  
Crossing Status: Found  
UCIP Comments: 03/27/2014 No lid on riser at WS shoulder could be safety issue. (W. Wylie - DWR UCIP)  
FIELD\_STRUCT\_DESC: [Rounder Irrigation Structure] 2 of 2: 36-inch corrugated metal gravity drainage pipe through the levee, 12.3 feet below the crown. Slide gate in a 48-inch corrugated metal pipe (CMP) riser on the waterside (WS) slope. 6-foot by 12-foot concrete distribution box on the landside (LS). 7-foot by 14-foot concrete outlet structure on the WS toe. [Additional Reference(s): DWR Levee Log, 2002 (HLM 1.14), listed as a 36-inch corrugated metal pipe (CMP). USACE San Joaquin O&M Manual, Unit 601 Part 1 (SJR601.1), 1967, (HLM 1.14), listed as a 36-inch CMP].  
FS Date: 3/27/2014

Slide gate in CMP riser without at lid on WS shoulder.

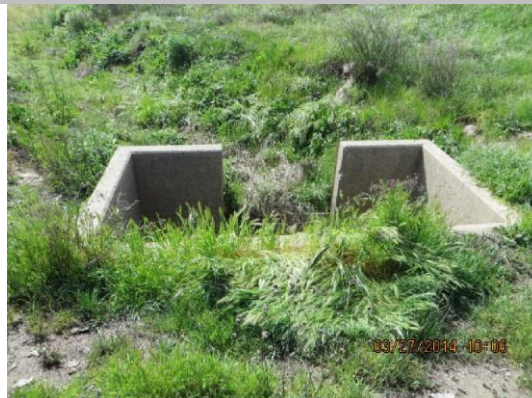
Photo 2 of 3 : UCIP\_SP\_2021\_62081\_59392.jpg

Concrete distribution box on WS toe.

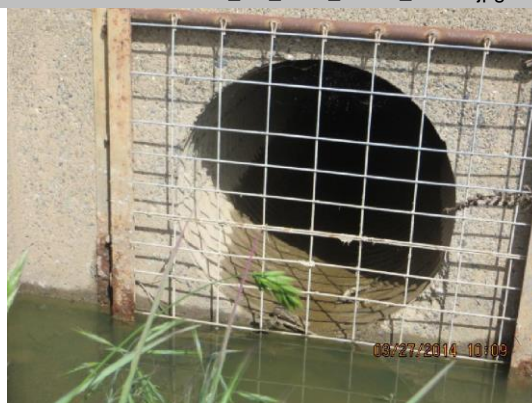
Photo 3 of 3 : UCIP\_SP\_2021\_62081\_59391.jpg

Pipe at outlet on WS toe.

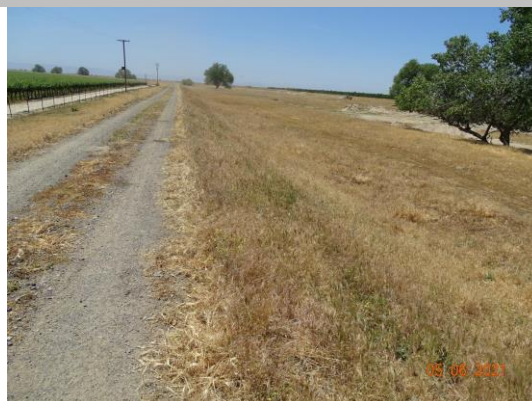
Photo 1 of 1 : SP\_2021\_NA0010\_132\_7\_20210518\_00010.jpg

LM Start	0.01	Rating **	M	Issue No.	7
LM End	1.11	Issue Type +	Ma	Location *	WS
Category	Earthen Levee			GPS Latitude/Longitude	
				Start	End
Item	Vegetation			37.032557 °	37.044786 °
				-120.441201 °	-120.430250 °
DWR ID	DWR_NA0010_14_s_2021_7				
Comment Code					
V1 : Control annual grass and weeds on the levee slopes and easements.					
Inspector Comment

View of the waterside slope looking downstream. (Spring 2021)

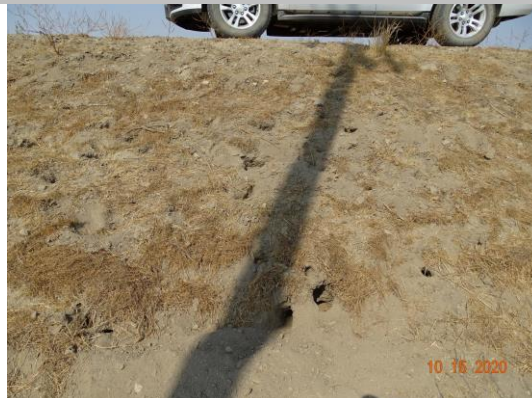
Photo 1 of 1 : SP\_2021\_NA0010\_132\_79\_20210308\_00003.jpg

LM Start	1.24	Rating **	M	Issue No.	79
LM End	1.24	Issue Type +	Ma	Location *	LS
Category	Earthen Levee			GPS Latitude/Longitude	
				Start	End
Item	Animal Control			37.045343 °	37.045343 °
				-120.428007 °	-120.428007 °
DWR ID	DWR_NA0010_14_s_2021_79				
Comment Code					
A3 : No rodents visible, but rodent burrows visible; need to backfill and compact or grout burrows.					
Inspector Comment					
Several rodent holes are noted on the landside at this location.

View of rodent burrows on the landside slope. (Fall 2020)

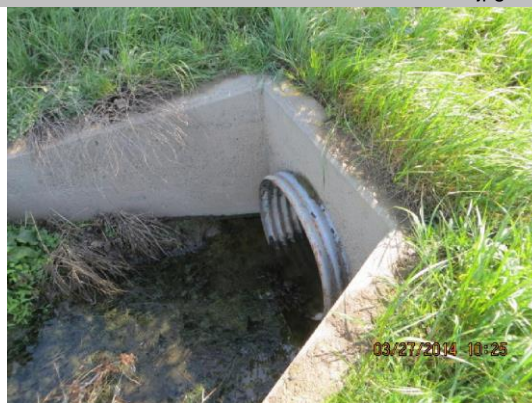
Photo 1 of 3 : UCIP\_SP\_2021\_62083\_59402.jpg

Concrete U-shaped headwall on Ws toe.

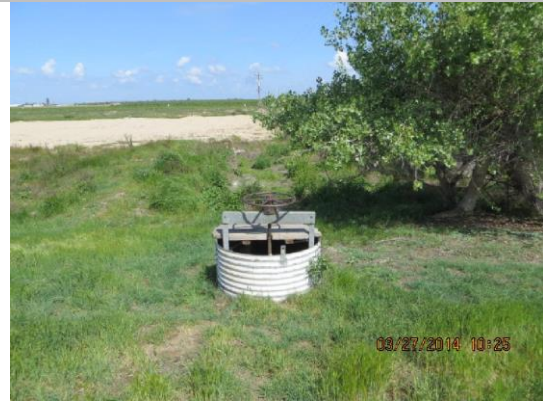
Photo 2 of 3 : UCIP\_SP\_2021\_62083\_59401.jpg

slidegate in CMP riser on WS slope.

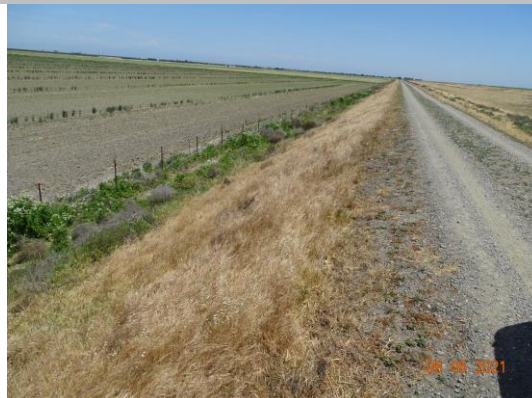
Photo 1 of 1 : SP\_2021\_NA0010\_133\_4\_20210518\_00012.jpg

LM Start	0.07	Rating **	M	Issue No.	4
LM End	0.60	Issue Type +	Ma	Location *	LS
Category	Earthen Levee			GPS Latitude/Longitude	
				Start	End
Item	Vegetation			36.996562 °	36.996552 °
				-120.409246 °	-120.399599 °
DWR ID	DWR_NA0010_15_s_2021_4				
Comment Code					
V1 : Control annual grass and weeds on the levee slopes and easements.					
Inspector Comment

Looking upstream along the landside slope. (Spring 2021)

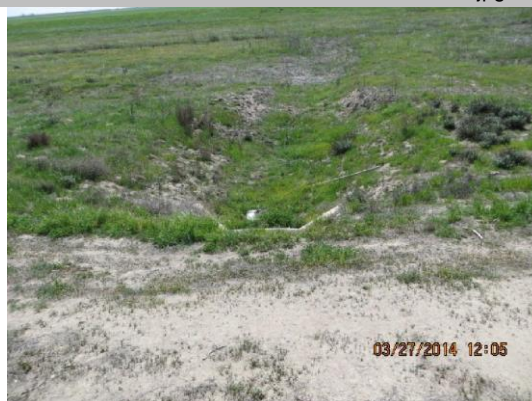
Photo 1 of 3 : UCIP\_SP\_2021\_62084\_59448.jpg

Concrete headwall on WS toe.

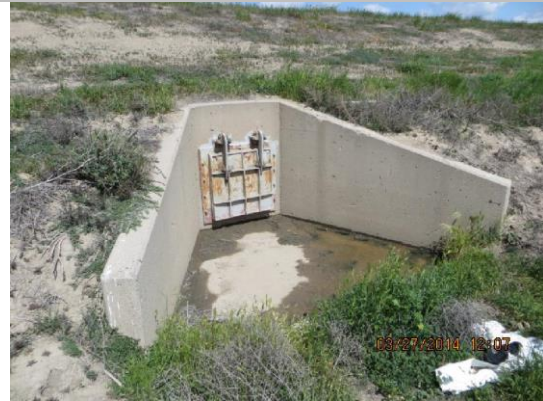
Photo 2 of 3 : UCIP\_SP\_2021\_62084\_59449.jpg

Flapgate on Concrete headwall at WS toe.

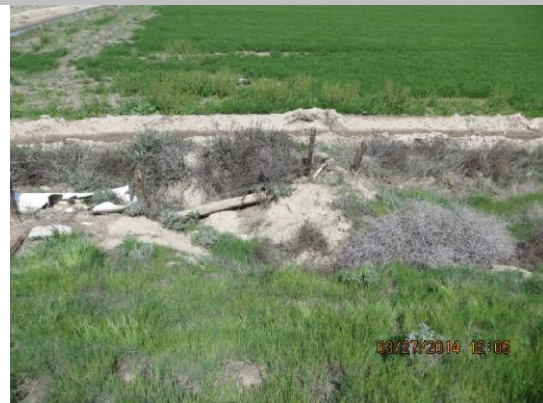
Photo 3 of 3 : UCIP\_SP\_2021\_62084\_59447.jpg

Concrete headwall on LS toe.

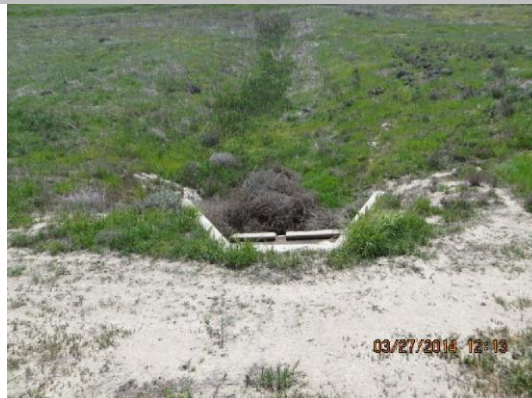
Photo 1 of 3 : UCIP\_SP\_2021\_62085\_59452.jpg

Concrete headwall on WS toe.

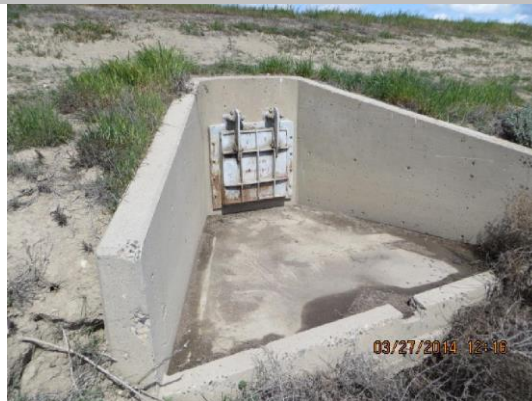
Photo 2 of 3 : UCIP\_SP\_2021\_62085\_59453.jpg

Flapgate on concrete headwall at WS toe.

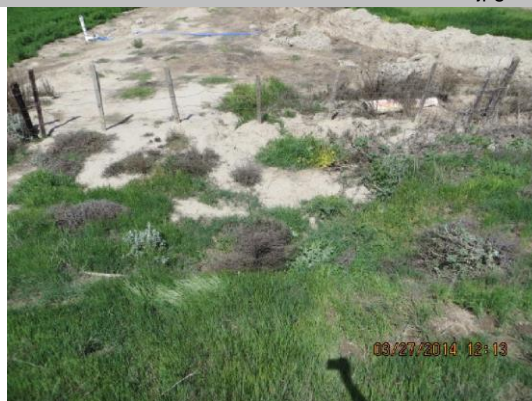
Photo 3 of 3 : UCIP\_SP\_2021\_62085\_59451.jpg

FS\_ID:62085  
DS\_ID:19912  
EP\_NO: N/A  
Repair Type: Non-Urgent  
Crossing Status: Found  
UCIP Comments: 03/27/2014 Dense vegetation limits the inspector's visibility to identify signs of pipe failure (leaks) along the landward slope. Recommend removing vegetation along pipe alignment to conduct proper inspection of structure. (W. Wylie - DWR UCIP)  
FIELD\_STRUCT\_DESC: 30-inch by 30-inch square reinforced concrete box gravity drainage culvert through the levee, 8.5 feet below the crown. Flap gate on the waterside (WS) end. Concrete headwall on the landside (LS) end. Concrete U-shaped headwall on the WS end.  
[Additional Reference(s): DWR Levee Log, 2002 (HLM 1.01), listed as a 30-inch square reinforced concrete box culvert (RCBC). USACE San Joaquin O&M Manual, Unit 601 Part 1 (SJR601.1), 1967, (HLM 1.01), listed as a 2.5-feet by 2.5-feet RCBC].  
FS Date: 3/27/2014

Concrete headwall on LS toe.

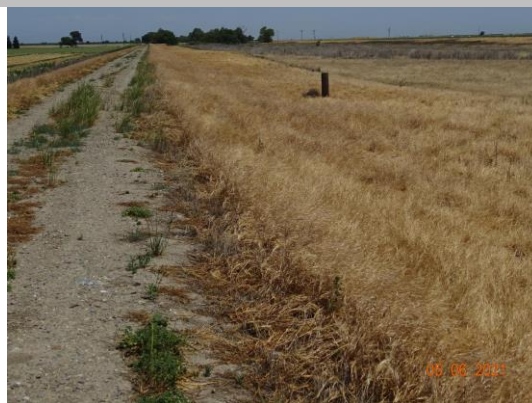
Photo 1 of 1 : SP\_2021\_NA0010\_133\_7\_20210518\_00014.jpg

LM Start	1.52	Rating **	U	Issue No.	7
LM End	2.01	Issue Type +	Ma	Location *	WS
Category	Earthen Levee			GPS Latitude/Longitude	
				Start	End
Item	Vegetation			36.996570 °	36.996594 °
				-120.382936 °	-120.374154 °
DWR ID	DWR_NA0010_15_s_2021_7				
Comment Code					
V1 : Control annual grass and weeds on the levee slopes and easements.					
Inspector Comment

Looking upstream along the waterside slope. (Spring 2021)

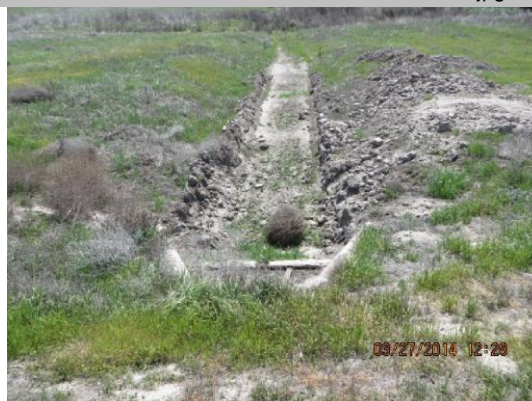
Photo 1 of 3 : UCIP\_SP\_2021\_62086\_59456.jpg

Concrete headwall on WS toe.

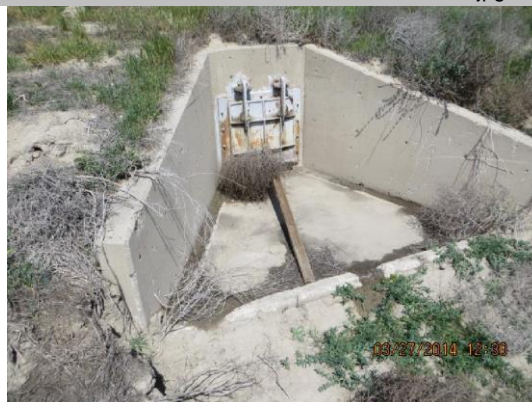
Photo 2 of 3 : UCIP\_SP\_2021\_62086\_59457.jpg

Flapgate on concrete headwall at WS toe.

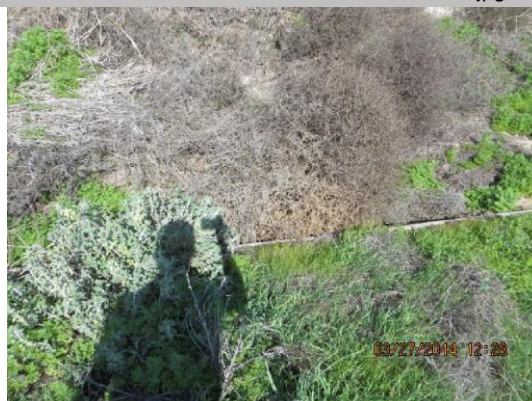
Photo 3 of 3 : UCIP\_SP\_2021\_62086\_59455.jpg

Comment Code						
Inspector Comment						
FS_ID:62086						
DS_ID:19913						
EP_NO: N/A						
Repair Type: Non-Urgent						
Crossing Status: Found						
UCIP Comments: 03/27/2014 Excessive vegetation at inlet on LS toe.

Concrete headwall on LS toe. Note excessive vegetation buildup.

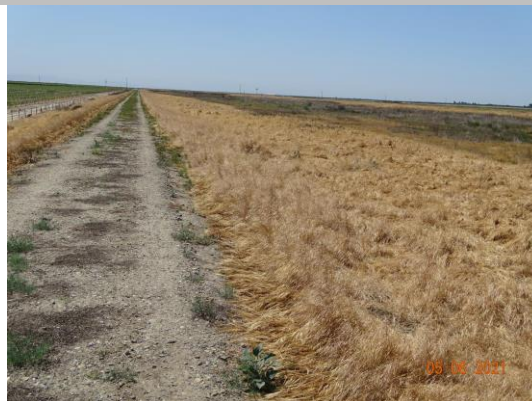
Photo 1 of 1 : SP\_2021\_NA0010\_134\_6\_20210518\_00009.jpg

LM Start	<b>0.22</b>	Rating **	U	Issue No.	<b>6</b>
LM End	<b>1.95</b>	Issue Type +	Ma	Location *	WS
Category	Earthen Levee		GPS Latitude/Longitude		
			Start	End	
Item	Vegetation		36.995417 °	36.995497 °	
			-120.405021 °	-120.373651 °	
DWR ID	DWR_NA0010_16_s_2021_6				
Comment Code					
V1 : Control annual grass and weeds on the levee slopes and easements.					
Inspector Comment

View of the waterside slope looking downstream. (Spring 2021)

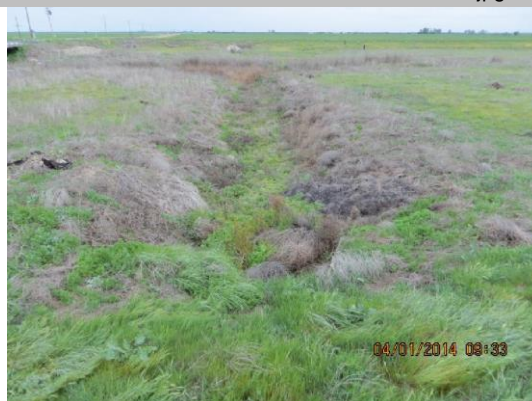
Photo 1 of 3 : UCIP\_SP\_2021\_62089\_59681.jpg

Concrete headwall on WS toe with channel.

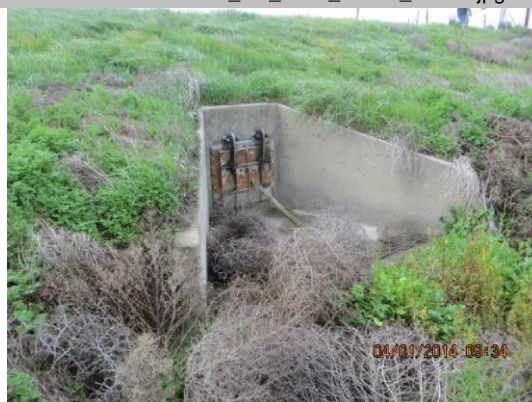
Photo 2 of 3 : UCIP\_SP\_2021\_62089\_59680.jpg

Flapgate on headwall at WS toe.

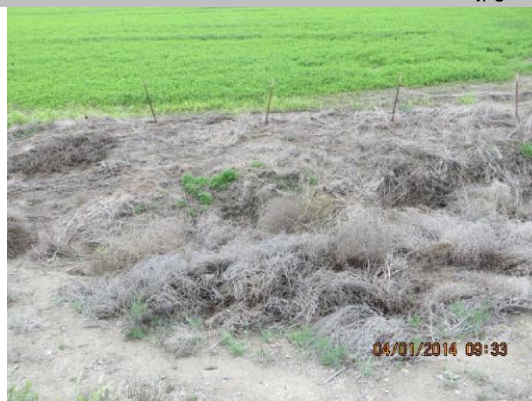
Photo 3 of 3 : UCIP\_SP\_2021\_62089\_59682.jpg

Comment Code					
Inspector Comment					
FS_ID:62089 DS_ID:19915 EP_NO: N/A Repair Type: Non-Urgent Crossing Status: Found UCIP Comments: 04/01/2014 Dense vegetation buildup at landside toe--recommend clearing. (W. Wylie - DWR UCIP) FIELD_STRUCT_DESC: 30-inch by 30-inch square reinforced concrete box gravity drainage culvert through the levee, 8.5 feet below the crown. Two concrete cutoff walls. Flap gate on the waterside (WS) end. Concrete headwall on the landside (LS) end. Concrete U-shaped headwall on the WS end. [Additional Reference(s): DWR Levee Log, 2002 (HLM 1.46), listed as a 30-inch square reinforced concrete box culvert (RCBC). USACE San Joaquin O&M Manual, Unit 601 Part 1 (SJR601.1), 1967, (HLM 1.46), listed as a 2.5-feet by 2.5-feet RCBC]. FS Date: 4/1/2014 8:12:00 AM

Concrete headwall on LS toe covered in vegetation/tumble weeds.

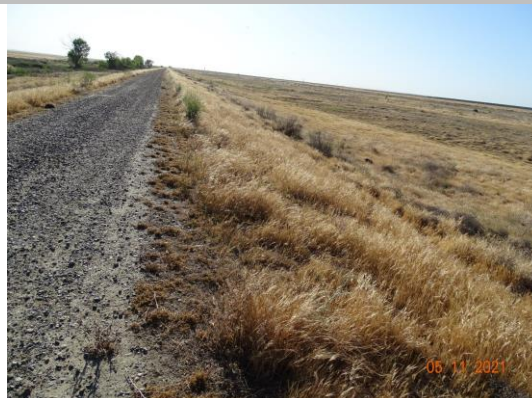
Photo 1 of 1 : SP\_2021\_NA0010\_135\_13\_20210518\_00035.jpg

LM Start	0.00	Rating **	U	Issue No.	13
LM End	7.62	Issue Type +	Ma	Location *	WS
Category	Earthen Levee			GPS Latitude/Longitude	
				Start	End
Item	Vegetation			36.976437 °	36.883195 °
				-120.374709 °	-120.319412 °
DWR ID	DWR_NA0010_17_s_2021_13				
Comment Code					
V1 : Control annual grass and weeds on the levee slopes and easements.					
Inspector Comment

View of the waterside slope looking upstream. (Spring 2021)

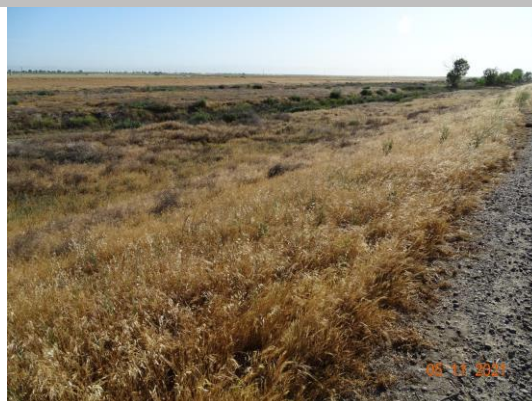
Photo 1 of 1 : SP\_2021\_NA0010\_135\_12\_20210520\_00036.jpg

LM Start	0.00	Rating **	U	Issue No.	12
LM End	7.61	Issue Type +	Ma	Location *	LS
Category	Earthen Levee			GPS Latitude/Longitude	
				Start	End
Item	Vegetation			36.976438 °	36.883245 °
				-120.374709 °	-120.319430 °
DWR ID	DWR_NA0010_17_s_2021_12				
Comment Code					
V1 : Control annual grass and weeds on the levee slopes and easements.					
Inspector Comment

View of the vegetation on the landside slope looking upstream. (Spring 2021)

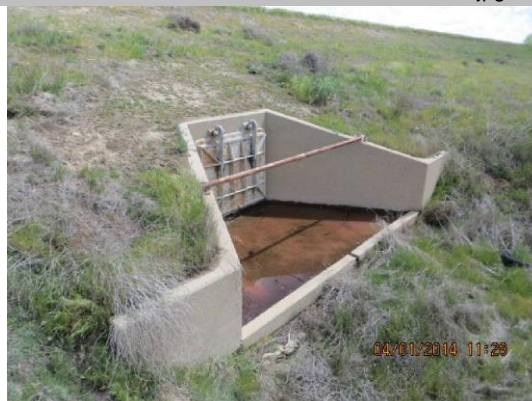
Photo 2 of 3 : UCIP\_SP\_2021\_62099\_59711.jpg

Comment Code						
Inspector Comment						
FS_ID:62099 DS_ID:19916 EP_NO: N/A Repair Type: Non-Urgent Crossing Status: Found UCIP Comments: 04/01/2014 Dense vegetation limits the inspector's visibility to identify signs of pipe failure (leaks) along the landward slope. Recommend removing vegetation along pipe alignment to conduct proper inspection of structure. (W. Wylie - DWR UCIP) FIELD_STRUCT_DESC: 48-inch by 60-inch reinforced concrete box gravity drainage culvert through the levee, 14.6 feet below the crown. Flap gate on the waterside (WS) end. Concrete headwall on the landside (LS) end. Concrete U-shaped headwall on the WS end. [Additional Reference(s): DWR Levee Log, 2002 (HLM 2.58), listed as a 48-inch by 60-inch reinforced concrete box culvert (RCBC). USACE San Joaquin O&M Manual, Unit 601 Part 1 (SJR601.1), 1967, (HLM 2.58), listed as a 5-feet by 4-feet RCBC]. FS Date: 4/1/2014

Flapgate on Concrete headwall at WS toe.

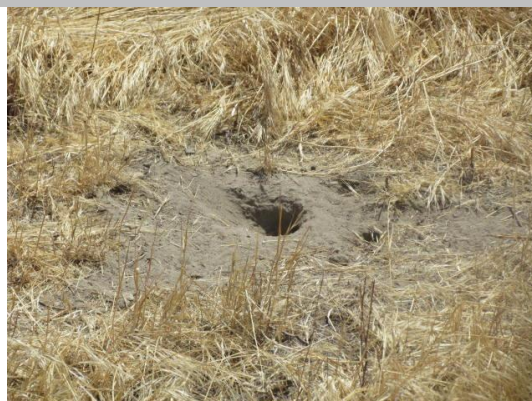
Photo 1 of 1 : SP\_2021\_NA0010\_135\_4\_20210308\_00002.jpg

LM Start	6.51	Rating **	M	Issue No.	4
LM End	6.72	Issue Type +	Ma	Location *	LS
Category	Earthen Levee			GPS Latitude/Longitude	
				Start	End
Item	Animal Control			36.898093 °	36.895300 °
				-120.326689 °	-120.325322 °
DWR ID	DWR_NA0010_17_s_2012_4				
Comment Code					
A1 : Exterminate rodents and backfill and compact or grout burrows.					
Inspector Comment					
Several rodent holes are identified within this reach.

Looking at typical view of rodent holes on landward slope.

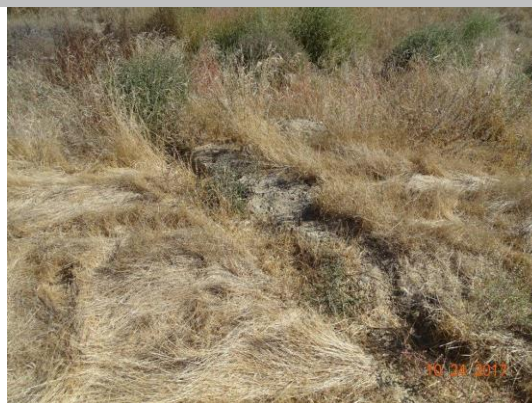
Photo 1 of 1 : SP\_2021\_NA0010\_135\_24\_20210308\_00010.jpg

LM Start	8.15	Rating **	M	Issue No.	24
LM End	8.15	Issue Type +	Ma	Location *	LS
Category	Earthen Levee			GPS Latitude/Longitude	
				Start	End
Item	Animal Control			36.875525 °	36.875525 °
				-120.317788 °	-120.317788 °
DWR ID	DWR_NA0010_17_f_2017_24				
Comment Code					
A3 : No rodents visible, but rodent burrows visible; need to backfill and compact or grout burrows.					
Inspector Comment					
Rodent holes are on the landside and crown of levee. Rodent holes have caused some erosion on the landside slope.

Looking east at the landside slope.

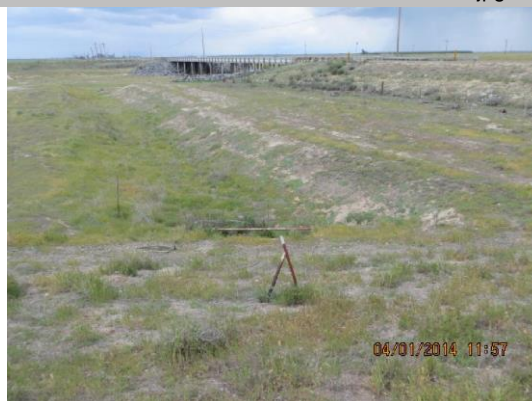
Photo 1 of 3 : UCIP\_SP\_2021\_62092\_59718.jpg

Comment Code						
Inspector Comment						
FS_ID:62092						
DS_ID:19922						
EP_NO: N/A						
Repair Type: No Action Needed						
Crossing Status: Found						
UCIP Comments:						
FIELD_STRUCT_DESC: 48-inch by 60-inch reinforced concrete box gravity drainage culvert through the levee, 16.5 feet below the crown. Flap gate on the waterside (WS) end. Concrete headwall on the landside (LS) end. Concrete U-shaped headwall on the WS end. [Additional Reference(s): DWR Levee Log, 2002 (HLM 8.38), listed as a 48-inch by 60-inch reinforced concrete box culvert (RCBC). USACE San Joaquin O&M Manual, Unit 601 Part 1 (SJR601.1), 1967, (HLM 8.38), listed as a 5-feet by 4-feet RCBC].						
FS Date: 4/1/2014

Concrete headwall and channel on WS toe.
