**Flood Control Project Maintenance  
Levee Inspections**

## Maintenance Issue Types Only, Levee Inspection Report By Mile - Spring 2021

### Lower San Joaquin Levee District

Waterway	Bank	Unit Miles	Inspection Start/End	Inspector
Unit No. 01 San Joaquin River	Right	22.52	05/04/2021 05/04/2021	Corey Fujitani

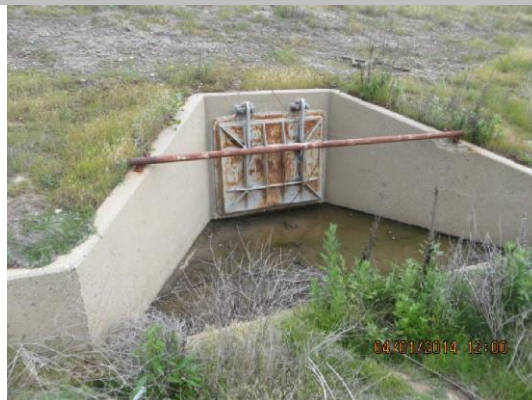
Photo 2 of 3 : UCIP\_SP\_2021\_62092\_59720.jpg

Flapgate on concrete headwall at WS toe.

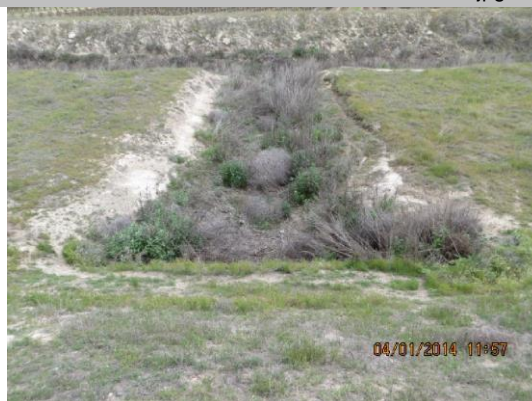
Photo 3 of 3 : UCIP\_SP\_2021\_62092\_59719.jpg

Concrete headwall and channel on LS toe.

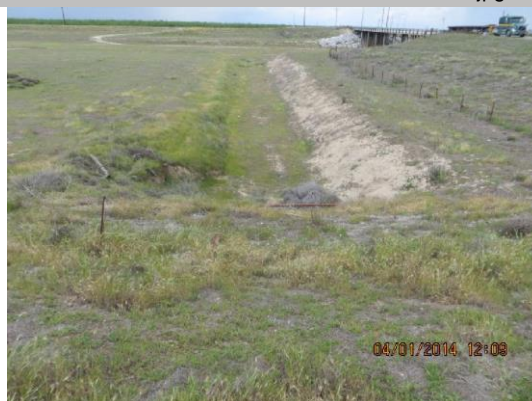
Photo 1 of 3 : UCIP\_SP\_2021\_62093\_59723.jpg

Comment Code						
Inspector Comment						
FS_ID:62093 DS_ID:19917 EP_NO: N/A Repair Type: Non-Urgent Crossing Status: Found UCIP Comments: 04/01/2014 Dense vegetation limits the inspector's visibility to identify signs of pipe failure (leaks) along the landward slope. Recommend removing vegetation along pipe alignment to conduct proper inspection of structure. (W. Wylie - DWR UCIP) FIELD_STRUCT_DESC: 48-inch by 60-inch reinforced concrete box gravity drainage culvert through the levee, 15 feet below the crown. Concrete headwall on the landside (LS) end. Concrete U-shaped headwall on the waterside (WS) end. [Additional Reference(s): DWR Levee Log, 2002 (HLM 9.89), listed as a 48-inch by 60-inch reinforced concrete box culvert (RCBC). USACE San Joaquin O&M Manual, Unit 601 Part 1 (SJR601.1), 1967, (HLM 9.89), listed as a 5-feet by 4-feet RCBC]. FS Date: 4/1/2014

Concrete headwall and channel on WS toe.

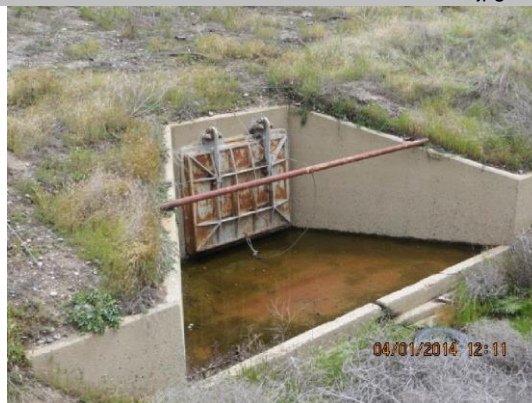
Photo 2 of 3 : UCIP\_SP\_2021\_62093\_59724.jpg

Flapgate on Concrete headwall at WS toe.

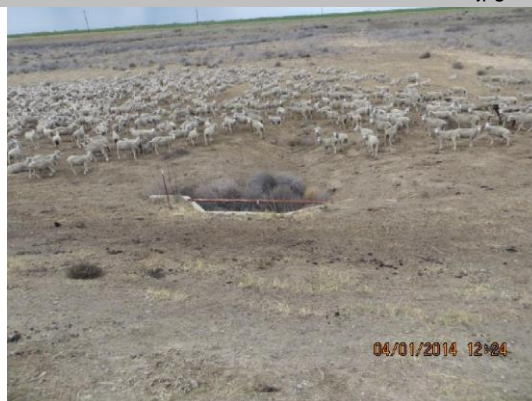
Photo 1 of 3 : UCIP\_SP\_2021\_62094\_59727.jpg

Comment Code					
Inspector Comment					
FS_ID:62094					
DS_ID:19918					
EP_NO: N/A					
Repair Type: Non-Urgent					
Crossing Status: Found					
UCIP Comments: 04/01/2014 Some vegetation buildup at inlet--recommend clearing. (W. Wylie - DWR UCIP)					
FIELD_STRUCT_DESC: 48-inch by 60-inch reinforced concrete box gravity drainage culvert through the levee, 15.3 feet below the crown. Flap gate on the waterside (WS) end. Concrete headwall on the landside (LS) end. Concrete U-shaped headwall on the WS end. [Additional Reference(s): DWR Levee Log, 2002 (HLM 13.29), listed as a 48-inch by 60-inch reinforced concrete box culvert (RCBC). USACE San Joaquin O&M Manual, Unit 601 Part 1 (SJR601.1), 1967, (HLM 13.30), listed as a 5-feet by 4-feet RCBC].					
FS Date: 4/1/2014

Concrete headwall on WS toe.

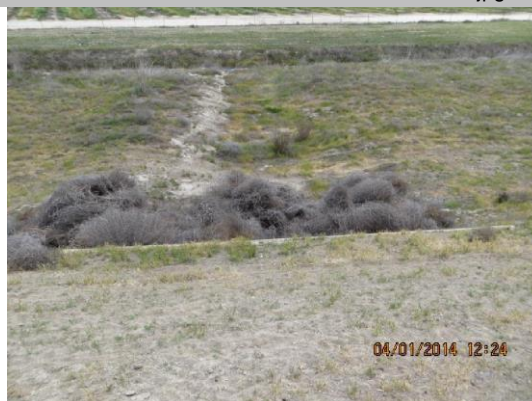
Photo 2 of 3 : UCIP\_SP\_2021\_62094\_59726.jpg

Concrete headwall on LS toe.

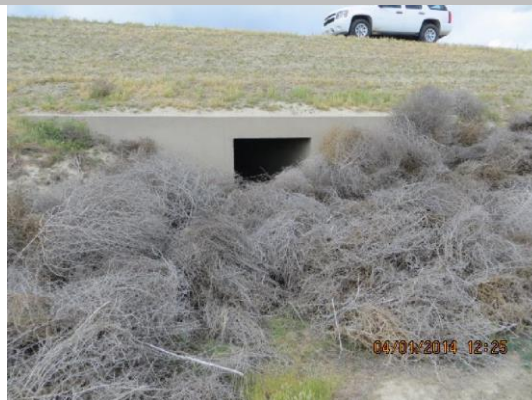
Photo 3 of 3 : UCIP\_SP\_2021\_62094\_59725.jpg

Concrete headwall on LS toe. Some vegetation buildup.

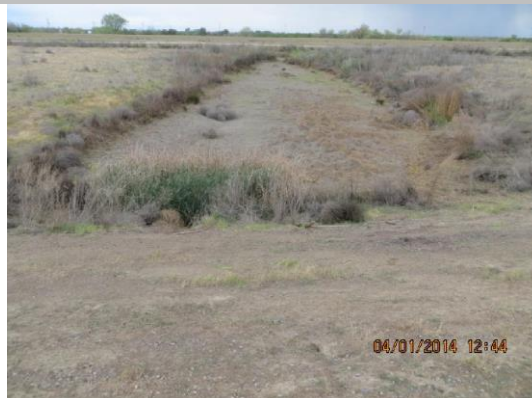
Photo 1 of 3 : UCIP\_SP\_2021\_62098\_59745.jpg

Comment Code					
Inspector Comment					
FS_ID:62098					
DS_ID:19920					
EP_NO: N/A					
Repair Type: Non-Urgent					
Crossing Status: Found					
UCIP Comments: 04/01/2014 Heavy vegetation buildup at LS toe--					
recommend clearing. (W. Wylie - DWR UCIP)					
FIELD_STRUCT_DESC: 30-inch by 30-inch square reinforced concrete					
box gravity drainage culvert through the levee, 14 feet below the crown.					
Flap gate on the waterside (WS) end. Concrete headwall on the					
landside (LS) end. Concrete U-shaped headwall on the WS end.					
[Additional Reference(s): DWR Levee Log, 2002 (HLM 14.70), listed as					
a 30-inch square reinforced concrete box culvert (RCBC). USACE San					
Joaquin O&M Manual, Unit 601 Part 1 (SJR601.1), 1967, (HLM 14.69),					
listed as a 2.5-feet by 2.5-feet RCBC].					
FS Date: 4/1/2014

Concrete headwall at WS toe.

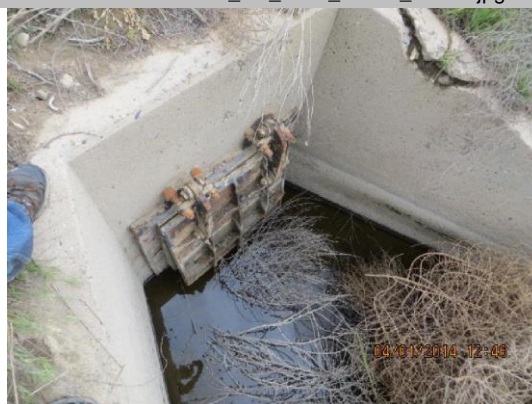
Photo 2 of 3 : UCIP\_SP\_2021\_62098\_59747.jpg

Flapgate on Concrete headwall at WS toe.

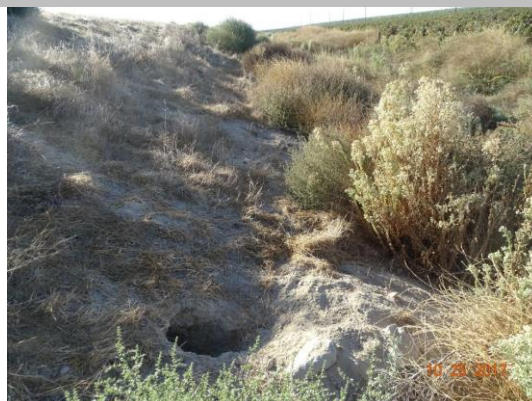
Photo 1 of 1 : SP\_2021\_NA0010\_137\_13\_20210308\_00006.jpg

LM Start	8.67	Rating **	U	Issue No.	13
LM End	8.67	Issue Type +	Ma	Location *	LS
Category	Earthen Levee			GPS Latitude/Longitude	
				Start	End
Item	Animal Control			36.856115 °	36.856115 °
				-120.316595 °	-120.316595 °
DWR ID	DWR_NA0010_18_f_2017_13				
Comment Code					
A3 : No rodents visible, but rodent burrows visible; need to backfill and compact or grout burrows.					
Inspector Comment

Looking south at the landside slope.

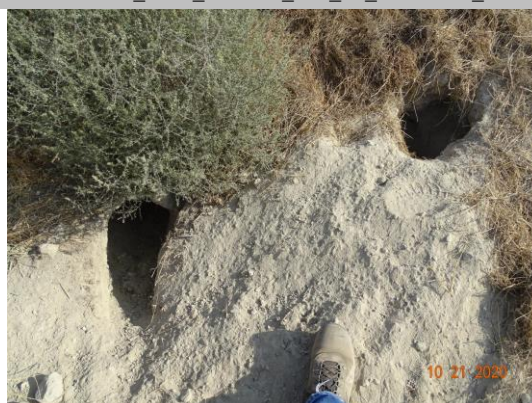
Photo 1 of 1 : SP\_2021\_NA0010\_137\_18\_20210308\_00010.jpg

LM Start	8.89	Rating **	U	Issue No.	18
LM End	8.89	Issue Type +	Ma	Location *	LS
Category	Earthen Levee			GPS Latitude/Longitude	
				Start	End
Item	Animal Control			36.852936 °	36.852936 °
				-120.316451 °	-120.316451 °
DWR ID	DWR_NA0010_18_f_2020_18				
Comment Code					
A3 : No rodents visible, but rodent burrows visible; need to backfill and compact or grout burrows.					
Inspector Comment

Large rodent holes in the landside slope. (Fall 2020)

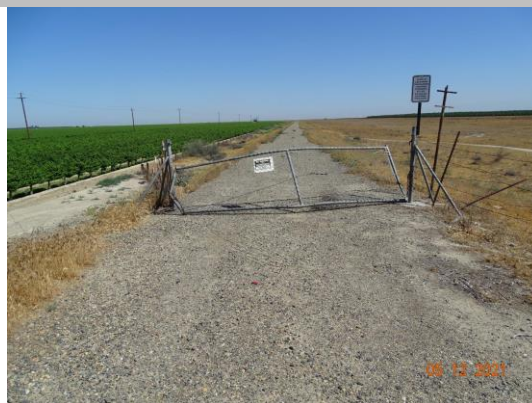
Photo 1 of 1 : SP\_2021\_NA0010\_137\_17\_20210520\_00031.jpg

LM Start	8.99	Rating **	U	Issue No.	17
LM End	8.99	Issue Type +	Ma	Location *	CR
Category	Earthen Levee			GPS Latitude/Longitude	
				Start	End
Item	Repair Gates			36.851459 °	36.851459 °
				-120.316387 °	-120.316387 °
DWR ID	DWR_NA0010_18_f_2020_17				
Comment Code					
Inspector Comment					
Gate has broken off the hinges and is no longer operable.

View of damaged access gate across the levee crown. (Spring 2021)

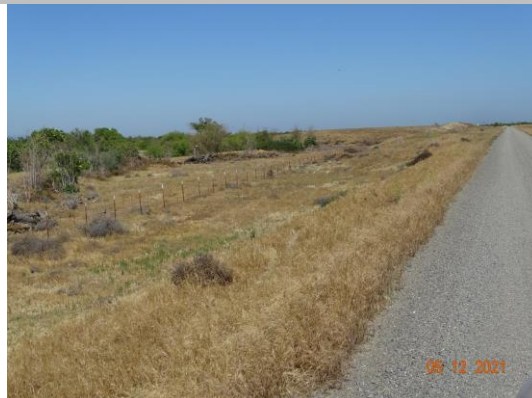
Photo 1 of 1 : SP\_2021\_NA0010\_137\_6\_20210520\_00032.jpg

LM Start	14.76	Rating **	M	Issue No.	6
LM End	14.97	Issue Type +	Ma	Location *	LS
Category	Earthen Levee			GPS Latitude/Longitude	
				Start	End
Item	Vegetation			36.779886 °	36.778088 °
				-120.291918 °	-120.288920 °
DWR ID	DWR_NA0010_18_s_2021_6				
Comment Code					
V1 : Control annual grass and weeds on the levee slopes and easements.					
Inspector Comment

View of vegetation on the landside slope. (Spring 2021)

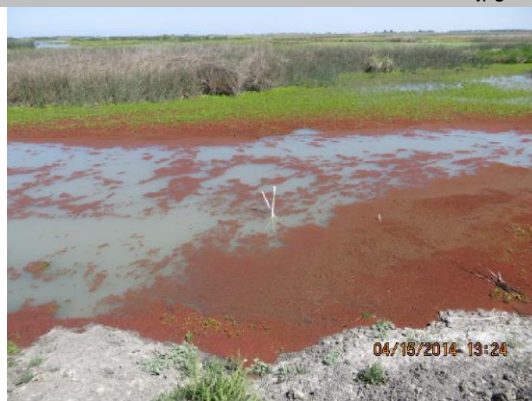
Photo 1 of 3 : UCIP\_SP\_2021\_62171\_61060.jpg

Comment Code						
Inspector Comment						
FS_ID:62171 DS_ID:19933 EP_NO: N/A Repair Type: Non-Urgent Crossing Status: Found UCIP Comments: 07/19/2016 Gate inside riser appears operable--riser lid damage. Crossing is not visible on LS due to dense vegetation. Recommend clearing dense vegetation along WS and LS slope and repairing riser cover. (O. Magana - DWR UCIP)04/15/2014 No actuator wheel on slide gate at WS shoulder. (W. Wylie - DWR UCIP) FIELD_STRUCT_DESC: 24-inch corrugated metal gravity drainage pipe through the levee, 14.8 feet below the crown. Slide gate in a 36-inch corrugated metal pipe (CMP) riser on the waterside (WS) slope. Concrete U-shaped headwall on each end. [Additional Reference(s): DWR Levee Log, 2002 (HLM 0.10), listed as a 24-inch corrugated metal pipe (CMP). USACE San Joaquin O&M Manual, Unit 601 Part 1 (SJR601.1), 1967, Revised 25 May 2011, (HLM 0.10), listed as a 24-inch CMP]. FS Date: 7/19/2016

PVC pipes sticking up out of channel likely indicate pipe location on WS toe.

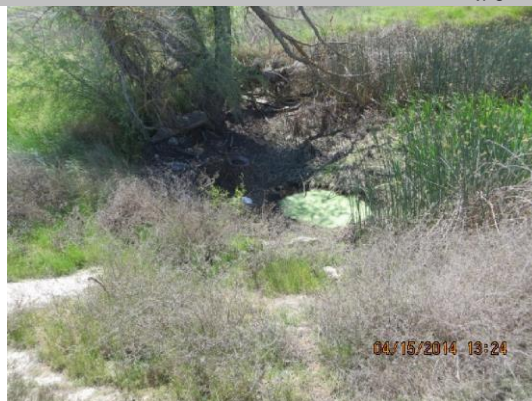
Photo 2 of 3 : UCIP\_SP\_2021\_62171\_61061.jpg

Concrete headwall at toe of LS slope.

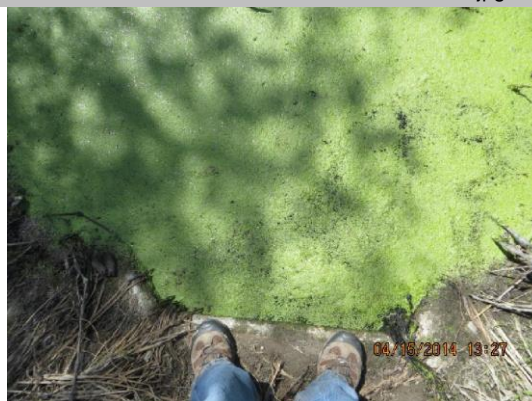
Photo 3 of 3 : UCIP\_SP\_2021\_62171\_61059.jpg

Concrete headwall at LS toe.

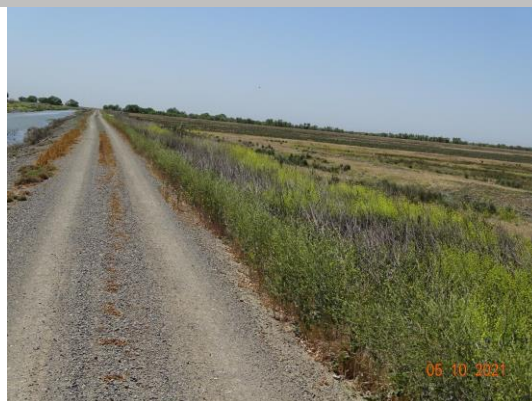
Photo 1 of 1 : SP\_2021\_NA0010\_138\_21\_20210520\_00045.jpg

LM Start	0.45	Rating **	U	Issue No.	21
LM End	1.42	Issue Type +	Ma	Location *	LS
Category	Earthen Levee			GPS Latitude/Longitude	
				Start	End
Item	Vegetation			37.211802 °	37.225553 °
				-120.697901 °	-120.700209 °
DWR ID	DWR_NA0010_22A_s_2021_21				
Comment Code					
V1 : Control annual grass and weeds on the levee slopes and easements.					
Inspector Comment

Dense vegetation growing on the landside slope. (Spring 2021)

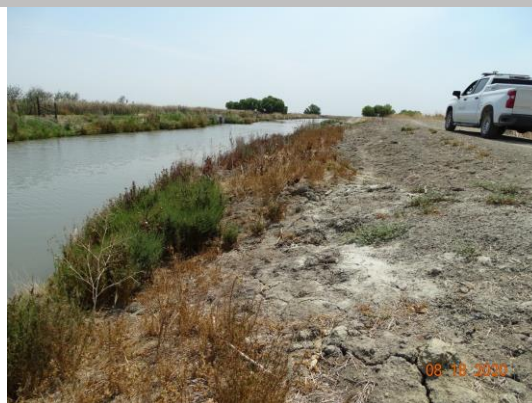
Photo 1 of 2 : SP\_2021\_NA0010\_138\_1\_20210308\_00001.jpg

LM Start	1.04	Rating **	M	Issue No.	1
LM End	1.04	Issue Type +	Ma	Location *	WS
Category	Supplemental			GPS Latitude/Longitude	
				Start	End
Item	DWR Erosion Survey			37.220281 °	37.220281 °
				-120.698287 °	-120.698287 °
DWR ID	NA0010U22RM5.47				
Comment Code					
Inspector Comment					
Site ID: NA0010U22RM5.47					
08/18/2020: No changes observed since the previous inspection.					
08/28/2019: Two erosion pockets were found at the site, close to levee shoulder, and likely caused by animal activities.

8/18/2020: View of the levee slope looking upstream.

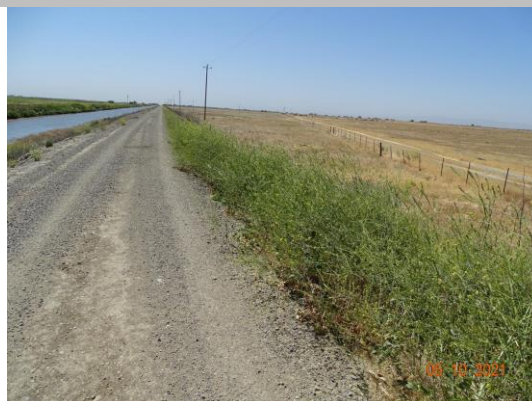
Photo 1 of 1 : SP\_2021\_NA0010\_138\_5\_20210520\_00046.jpg

LM Start	1.43	Rating **	M	Issue No.	5
LM End	2.62	Issue Type +	Ma	Location *	LS
Category	Earthen Levee			GPS Latitude/Longitude	
				Start	End
Item	Vegetation			37.225624 °	37.242154 °
				-120.700234 °	-120.706277 °
DWR ID	DWR_NA0010_22A_s_2021_5				
Comment Code					
V1 : Control annual grass and weeds on the levee slopes and easements.					
Inspector Comment

View of vegetation growing on the landside slope. (Spring 2021)

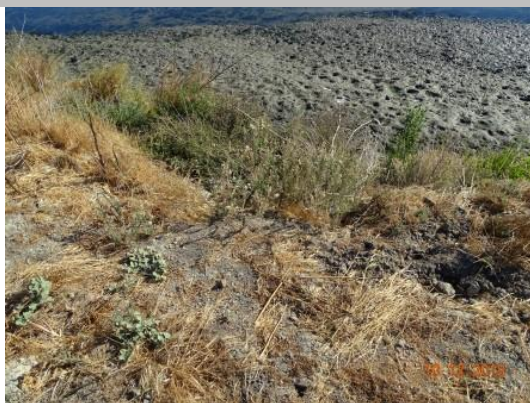
Photo 1 of 1 : SP\_2021\_NA0010\_138\_29\_20210308\_00029.jpg

LM Start	<b>2.20</b>	Rating **	M	Issue No.	<b>29</b>
LM End	<b>2.37</b>	Issue Type +	Ma	Location *	WS
Category	Earthen Levee		GPS Latitude/Longitude		
			Start	End	
Item	Animal Control		37.236392 °	37.238776 °	
			-120.704165 °	-120.705028 °	
DWR ID	DWR_NA0010_22A_f_2018_29				
Comment Code					
A2 : Repair the levee slope damaged by livestock and prevent large animal access.					
Inspector Comment					
There is slope erosion from livestock, the slope is no longer 3:1.

View of waterside slope from levee crown. (Fall 2018)

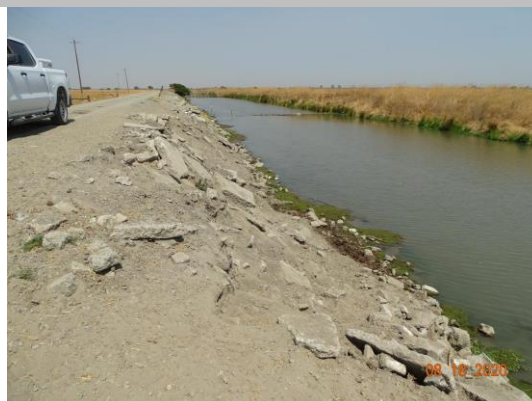
Photo 1 of 2 : SP\_2021\_NA0010\_138\_2\_20210308\_00003.jpg

LM Start	2.65	Rating **	U	Issue No.	2
LM End	2.66	Issue Type +	Ma	Location *	WS
Category	Supplemental			GPS Latitude/Longitude	
				Start	End
Item	DWR Erosion Survey			37.242595 °	37.242595 °
				-120.706470 °	-120.706470 °
DWR ID	NA0010U22RM3.87				
Comment Code					
Inspector Comment					
Site ID: NA0010U22RM3.87					
08/18/2020: The site has been covered with loose fill and crushed concrete pieces. The erosion will likely worsen again during the next high water.					
09/12/2019: The erosion has cut into the levee prism and damaged almost half of the levee. The livestock traffic has likely caused the erosion.

8/18/2020: View of the erosion looking downstream with fill and crushed concrete.

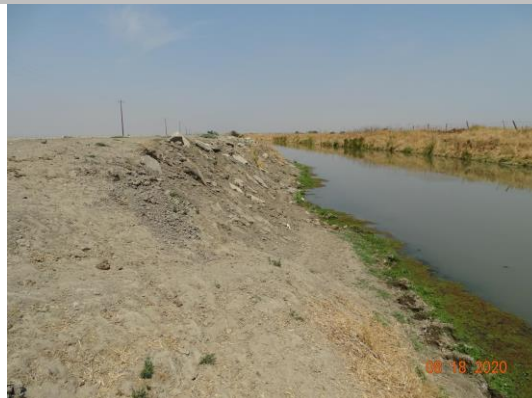
Photo 1 of 3 : SP\_2021\_NA0010\_138\_4\_20210308\_00008.jpg

LM Start	2.82	Rating **	U	Issue No.	4
LM End	2.83	Issue Type +	Ma	Location *	WS
Category	Supplemental			GPS Latitude/Longitude	
				Start	End
Item	DWR Erosion Survey			37.244940 °	37.244940 °
				-120.707467 °	-120.707467 °
DWR ID	NA0010U22RM3.7				
Comment Code					
Inspector Comment					
Site ID: NA0010U22RM3.7 08/18/2020: No changes observed since the previous inspection. In some areas, the levee shoulder width is up to 8 ft. There is some crushed concrete on the levee slope. 09/12/2019: The erosion has damaged entire levee slope. The livestock traffic likely has caused the erosion.

8/18/2020: View of the erosion looking downstream.

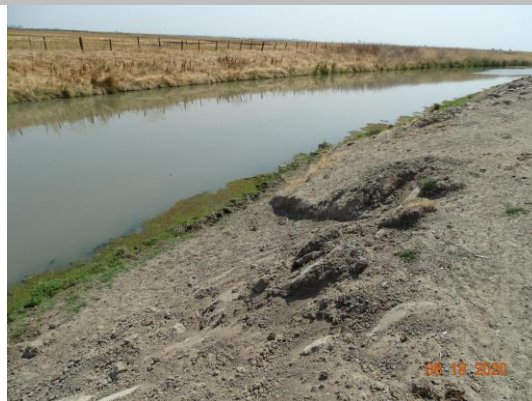
Photo 2 of 3 : SP\_2021\_NA0010\_138\_4\_20210308\_00009.jpg

8/18/2020: Close-up view of the erosion.

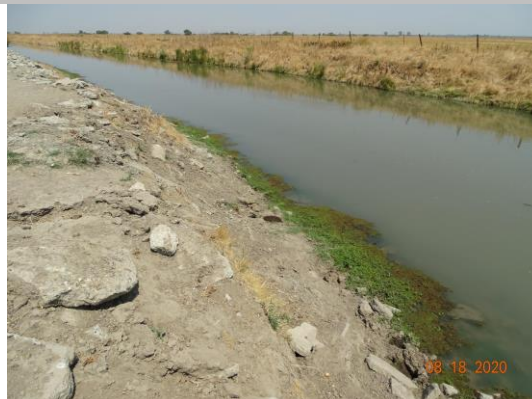
Photo 3 of 3 : SP\_2021\_NA0010\_138\_4\_20210308\_00010.jpg

8/18/2020: View of the erosion looking downstream with crushed concrete visible on the levee slope.

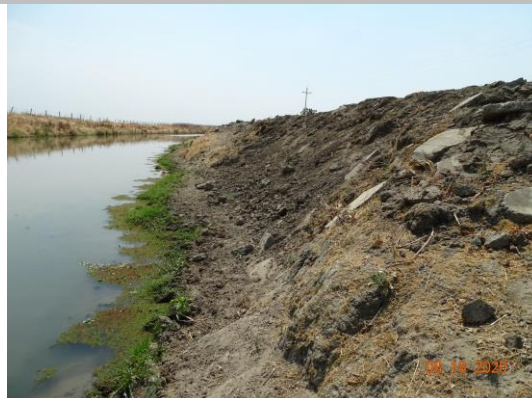
Photo 1 of 3 : SP\_2021\_NA0010\_138\_7\_20210308\_00013.jpg

LM Start	2.87	Rating **	U	Issue No.	7
LM End	2.87	Issue Type +	Ma	Location *	WS
Category	Supplemental			GPS Latitude/Longitude	
				Start	End
Item	DWR Erosion Survey			37.245536 °	37.245536 °
				-120.708119 °	-120.708119 °
DWR ID	NA0010U22RM3.65				
Comment Code					
Inspector Comment					
Site ID: NA0010U22RM3.65					
08/18/2020: No vegetation visible in the area of the erosion. Noticed some crushed concrete pieces on the levee slope and a small amount of loose fill.					
09/12/2019: The erosion has damaged entire levee slope. The livestock traffic likely has caused the erosion.

8/18/2020: View of the erosion looking upstream.

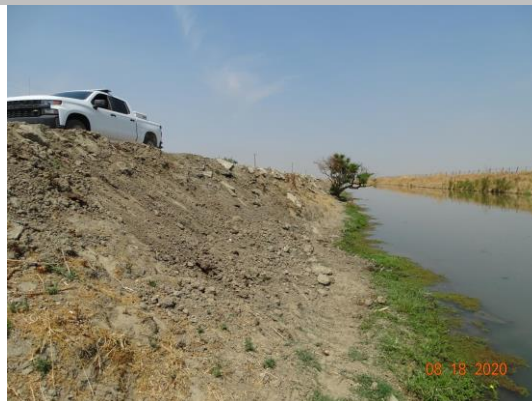
Photo 2 of 3 : SP\_2021\_NA0010\_138\_7\_20210308\_00014.jpg

8/18/2020: View of the erosion looking downstream.

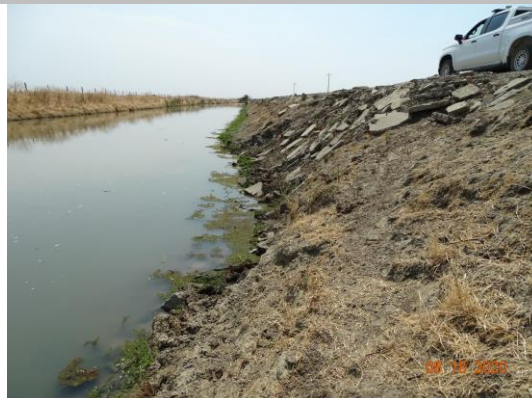
Photo 1 of 3 : SP\_2021\_NA0010\_138\_10\_20210308\_00018.jpg

LM Start	2.96	Rating **	U	Issue No.	10
LM End	2.97	Issue Type +	Ma	Location *	WS
Category	Supplemental			GPS Latitude/Longitude	
				Start	End
Item	DWR Erosion Survey			37.246408 °	37.246408 °
				-120.709197 °	-120.709197 °
DWR ID	NA0010U22RM3.56				
Comment Code					
Inspector Comment					
Site ID: NA0010U22RM3.56					
08/18/2020: The erosion has been covered with loose fill and crushed concrete pieces. A nearly vertical slope remains at the levee toe in some sections. The site will likely worsen again during the next high water.					
09/12/2019: The erosion has damaged entire levee slope. The livestock activity likely has caused the erosion.

8/18/2020: View of the erosion and crushed concrete on the slope.

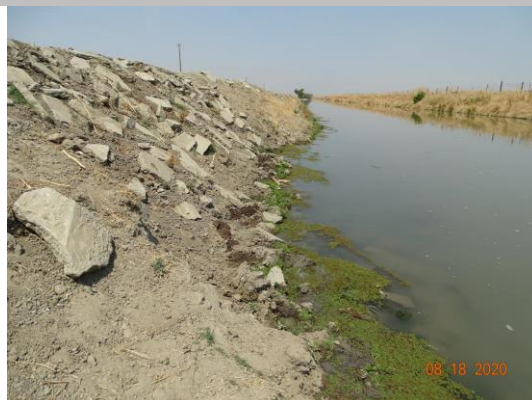
Photo 2 of 3 : SP\_2021\_NA0010\_138\_10\_20210308\_00019.jpg

8/18/2020: Close-up view of the erosion looking downstream.

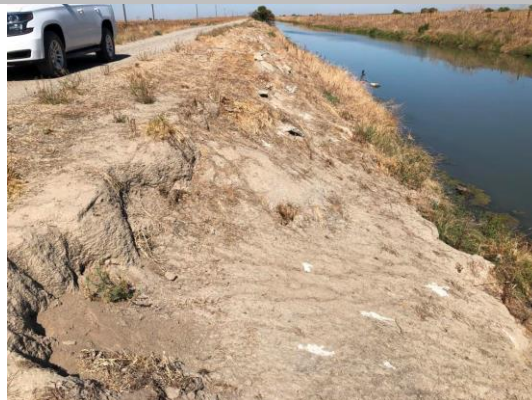
Photo 3 of 3 : SP\_2021\_NA0010\_138\_10\_20210308\_00020.jpg

9/12/2019: Looking down at the erosion pocket.

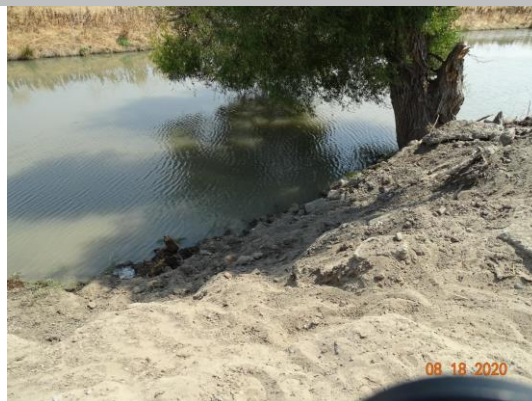
Photo 1 of 3 : SP\_2021\_NA0010\_138\_3\_20210308\_00005.jpg

LM Start	3.14	Rating **	U	Issue No.	3
LM End	3.15	Issue Type +	Ma	Location *	WS
Category	Supplemental			GPS Latitude/Longitude	
				Start	End
Item	DWR Erosion Survey			37.248257 °	37.248257 °
				-120.711547 °	-120.711547 °
DWR ID	NA0010U22RM3.38				
Comment Code					
Inspector Comment					
Site ID: NA0010U22RM3.38					
08/18/2020: The erosion has slightly worsened and cut into the levee prism. The site is immediately downstream of a tree on the levee toe.					
09/12/2019: The erosion has damaged the entire levee slope. Livestock activity likely has caused the erosion.

8/18/2020: View of the erosion looking down the levee slope.

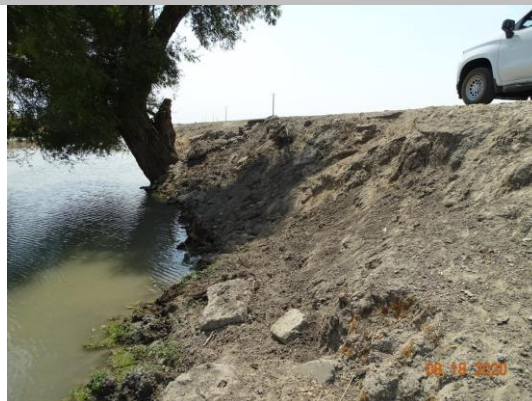
Photo 2 of 3 : SP\_2021\_NA0010\_138\_3\_20210308\_00006.jpg

8/18/2020: View of the erosion looking upstream.

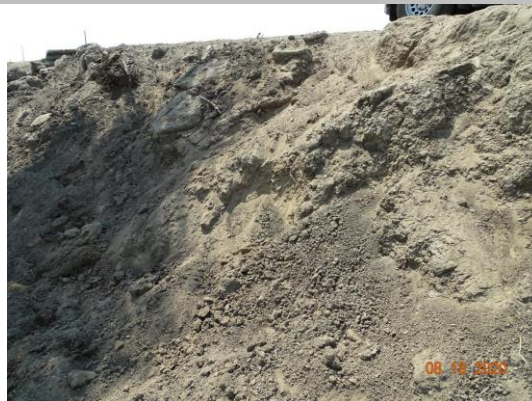
Photo 3 of 3 : SP\_2021\_NA0010\_138\_3\_20210308\_00007.jpg

8/18/2020: Close-up view of the erosion.

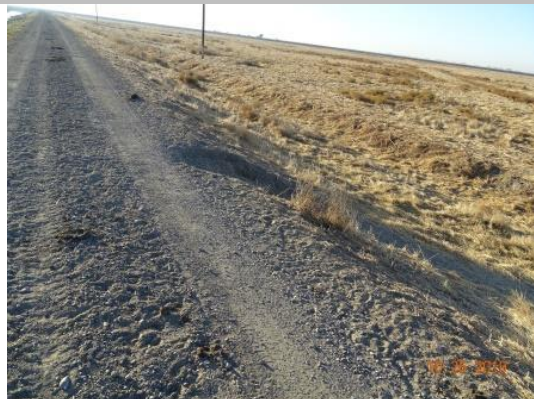
Photo 1 of 1 : SP\_2021\_NA0010\_138\_15\_20210308\_00026.jpg

LM Start	4.11	Rating **	M	Issue No.	15
LM End	4.11	Issue Type +	Ma	Location *	LS
Category	Earthen Levee			GPS Latitude/Longitude	
				Start	End
Item	Animal Control			37.258353 °	37.258353 °
				-120.723824 °	-120.723824 °
DWR ID	DWR_NA0010_22A_f _ 2019_15				
Comment Code					
A2 : Repair the levee slope damaged by livestock and prevent large animal access.					
Inspector Comment

View of erosion in the landside slope and shoulder from livestock traffic. (Fall 2019)

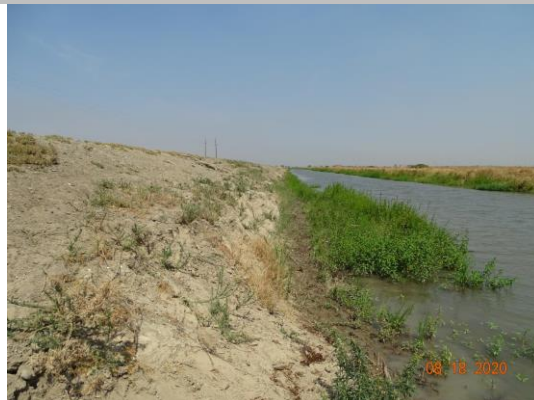
Photo 1 of 3 : SP\_2021\_NA0010\_138\_12\_20210308\_00021.jpg

LM Start	4.26	Rating **	U	Issue No.	12
LM End	4.30	Issue Type +	Ma	Location *	WS
Category	Supplemental			GPS Latitude/Longitude	
				Start	End
Item	DWR Erosion Survey			37.260111 °	37.260111 °
				-120.725900 °	-120.725900 °
DWR ID	NA0010U22RM2.25				
Comment Code					
Inspector Comment					
Site ID: NA0010U22RM2.25					
08/18/2020: No changes observed since the previous inspection.					
09/12/2019: Erosion has developed into the lower levee slope. Loose material was observed at the site.

8/18/2020: Close-up view of the erosion looking downstream.

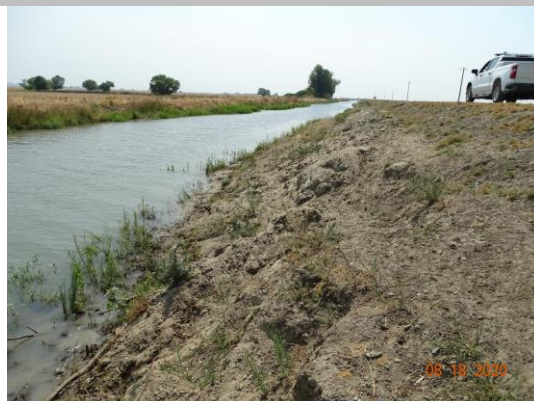
Photo 2 of 3 : SP\_2021\_NA0010\_138\_12\_20210308\_00022.jpg

8/18/2020: Close-up view of the erosion looking upstream.

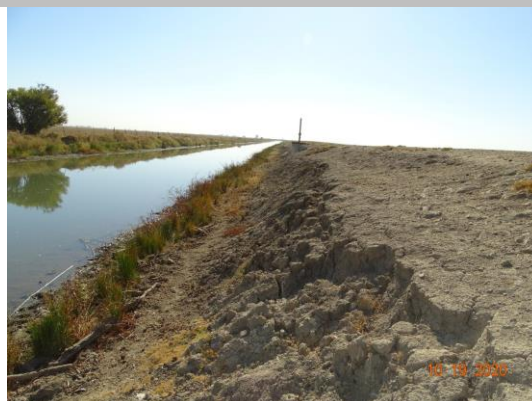
Photo 1 of 1 : SP\_2021\_NA0010\_138\_6\_20210308\_00012.jpg

LM Start	5.12	Rating **	M	Issue No.	6
LM End	5.49	Issue Type +	Ma	Location *	WS
Category	Earthen Levee			GPS Latitude/Longitude	
				Start	End
Item	Animal Control			37.268236 °	37.272262 °
				-120.737210 °	-120.741778 °
DWR ID	DWR_NA0010_22A_s_2012_6				
Comment Code					
A2 : Repair the levee slope damaged by livestock and prevent large animal access.					
Inspector Comment					
Slope damage is caused by livestock on waterside toe.

Looking southeast at livestock erosion on waterward toe. (Fall 2020)

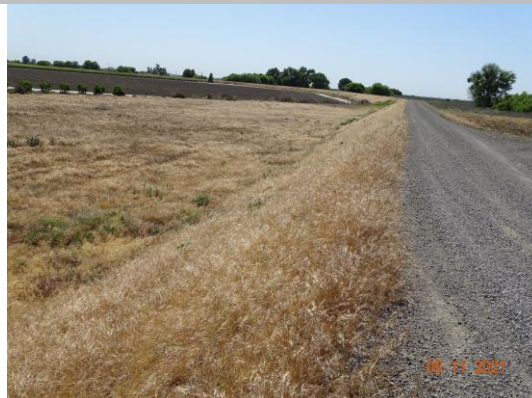
Photo 1 of 1 : SP\_2021\_NA0010\_139\_22\_20210520\_00040.jpg

LM Start	0.01	Rating **	M	Issue No.	22
LM End	4.33	Issue Type +	Ma	Location *	LS
Category	Earthen Levee			GPS Latitude/Longitude	
				Start	End
Item	Vegetation			36.774335 °	36.783882 °
				-120.283626 °	-120.225285 °
DWR ID	DWR_NA0010_23_s_2021_22				
Comment Code					
V1 : Control annual grass and weeds on the levee slopes and easements.					
Inspector Comment

View of the landside slope looking upstream. (Spring 2021)

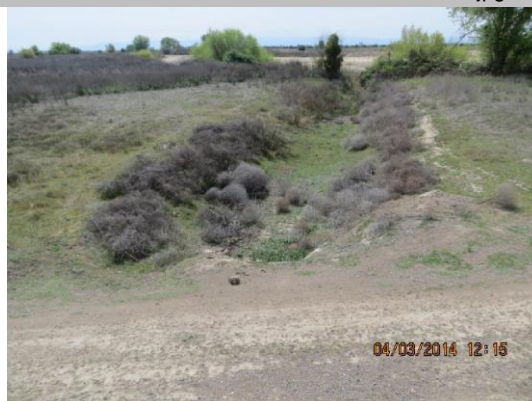
Photo 1 of 3 : UCIP\_SP\_2021\_62191\_59860.jpg

Comment Code						
Inspector Comment						
FS_ID:62191 DS_ID:19945 EP_NO: N/A Repair Type: Non-Urgent Crossing Status: Found UCIP Comments: 04/03/2014 Excessive vegetation at inlet--recommend clearing. (W. Wylie - DWR UCIP) FIELD_STRUCT_DESC: 30-inch by 30-inch square reinforced concrete box gravity drainage culvert through the levee, 13 feet below the crown. Flap gate on the waterside (WS) end. Concrete headwall on the landside (LS) end. Concrete U-shaped headwall on the WS end. (Plans to construct a new discharge structure and to rehabilitate one existing diversion structure to return intercepted seepage to the San Joaquin River authorized under Permit No. 13085, 1981 - Diener, Dry River Farms). [Additional Reference(s): DWR Levee Log, 2002 (HLM 0.21), listed as a 30-inch square reinforced concrete box culvert (RCBC). USACE San Joaquin O&M Manual, Unit 601 Part 1 (SJR601.1), 1967, Revised 25 May 2011, (HLM 0.21), listed as a 2.5-foot by 2.5-foot RCBC] FS Date: 4/3/2014

Concrete headwall on WS toe at channel.

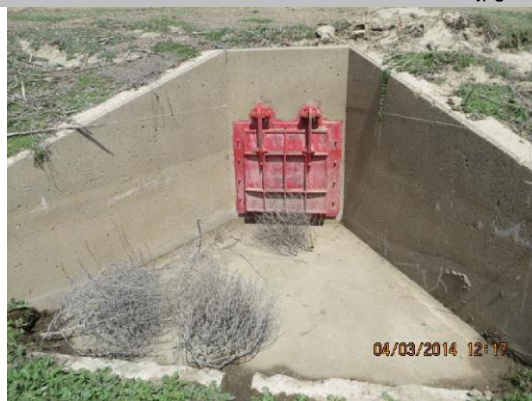
Photo 2 of 3 : UCIP\_SP\_2021\_62191\_59859.jpg

Flapgate on Concrete headwall at WS toe.

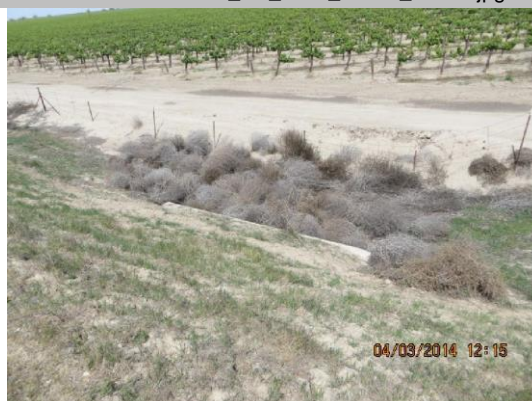
Photo 3 of 3 : UCIP\_SP\_2021\_62191\_59861.jpg

Concrete headwall at LS toe. Excess vegetation buildup at inlet.

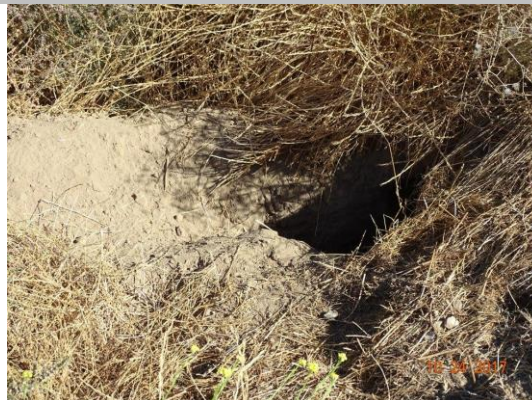
Photo 1 of 1 : SP\_2021\_NA0010\_139\_26\_20210308\_00006.jpg

LM Start	1.09	Rating **	M	Issue No.	26
LM End	1.09	Issue Type +	Ma	Location *	LS
Category	Earthen Levee			GPS Latitude/Longitude	
				Start	End
Item	Animal Control			36.772743 °	36.772743 °
				-120.266800 °	-120.266800 °
DWR ID	DWR_NA0010_23_f_2017_26				
Comment Code					
A3 : No rodents visible, but rodent burrows visible; need to backfill and compact or grout burrows.					
Inspector Comment					
Need to repair the large rodent hole on the landside slope.

Looking at the landside slope.

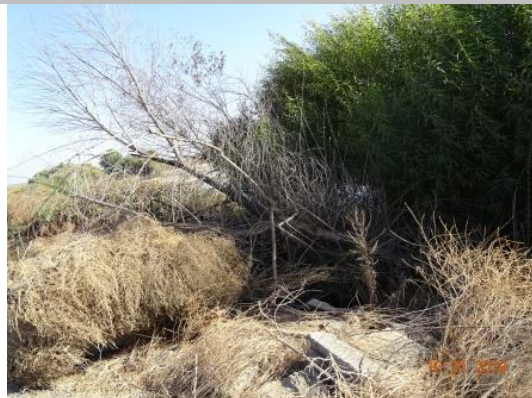
Photo 1 of 1 : SP\_2021\_NA0010\_139\_1\_20210308\_00001.jpg

LM Start	1.91	Rating **	M	Issue No.	1
LM End	1.91	Issue Type +	Ma	Location *	WS
Category	Earthen Levee			GPS Latitude/Longitude	
				Start	End
Item	Encroachments			36.772943 °	36.772943 °
				-120.253511 °	-120.253511 °
DWR ID	DWR_NA0010_23_s_2015_1				
Comment Code					
TR : Tree or limb					
Inspector Comment					
There is a downed tree on the waterside slope.

View of fallen tree on the waterside slope. (Fall 2019)

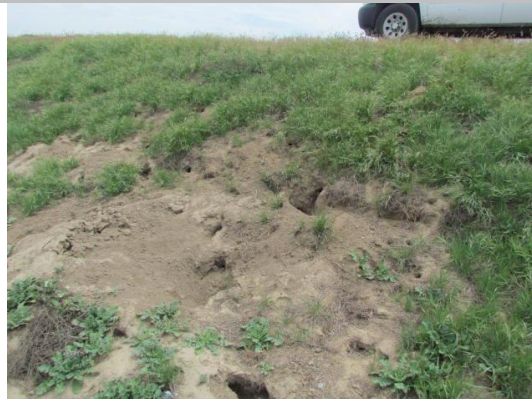
Photo 1 of 1 : SP\_2021\_NA0010\_139\_5\_20210308\_00002.jpg

LM Start	<b>5.68</b>	Rating **	M	Issue No.	<b>5</b>
LM End	<b>5.68</b>	Issue Type +	Ma	Location *	LS
Category	Earthen Levee		GPS Latitude/Longitude		
			Start	End	
Item	Animal Control		36.791981 °	36.791981 °	
			-120.206274 °	-120.206274 °	
DWR ID	DWR_NA0010_23_s_2012_5				
Comment Code					
A1 : Exterminate rodents and backfill and compact or grout burrows.					
Inspector Comment					
There are several large rodent holes in this area.

Looking at several rodent holes on landside slope.

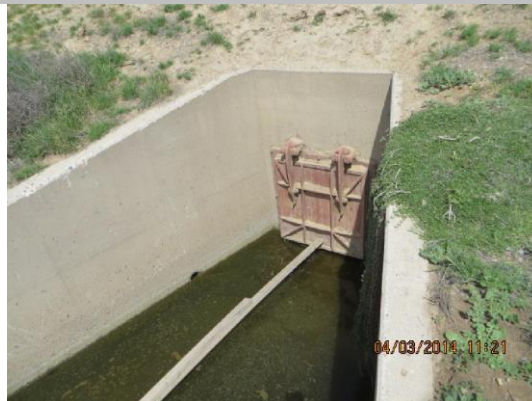
Photo 2 of 3 : UCIP\_SP\_2021\_62198\_59829.jpg

Flapgate on Concrete headwall on WS toe.

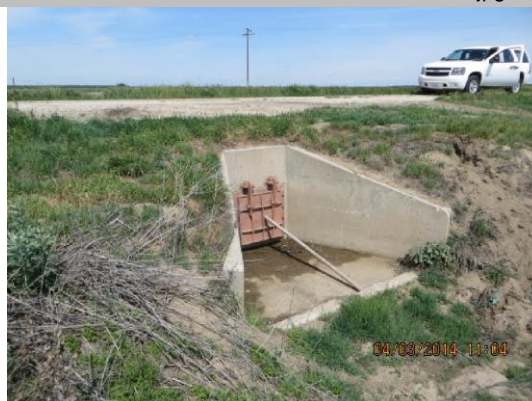
Photo 1 of 3 : UCIP\_SP\_2021\_62200\_59823.jpg

Comment Code						
Inspector Comment						
FS_ID:62200 DS_ID:19940 EP_NO: N/A Repair Type: Non-Urgent Crossing Status: Found UCIP Comments: 04/03/2014 Some sediment buildup at inlet at LS toe. Also dense vegetation limits the inspector's visibility to identify signs of pipe failure (leaks) along the landward slope. Recommend removing vegetation along pipe alignment to conduct proper inspection of structure. (W. Wylie - DWR UCIP) FIELD_STRUCT_DESC: 30-inch by 30-inch square reinforced concrete box gravity drainage culvert through the levee, 5.2 feet below the crown. Flap gate on the waterside (WS) end. Concrete headwall on the landside (LS) end. Concrete U-shaped headwall on the WS end. [Additional Reference(s): DWR Levee Log, 2002 (HLM 8.33), listed as a 30-inch square reinforced concrete box culvert (RCBC). USACE San Joaquin O&M Manual, Unit 601 Part 1 (SJR601.1), 1967, Revised 25 May 2011, (HLM 8.33), listed as a 2.5-foot by 2.5-foot RCBC] FS Date: 4/3/2014

Flapgate on WS toe.

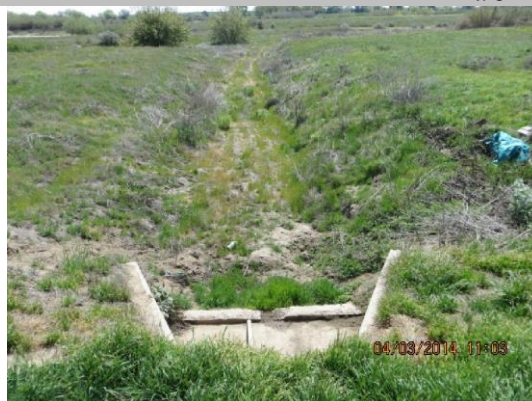
Photo 2 of 3 : UCIP\_SP\_2021\_62200\_59821.jpg

cocrete headwall at drainage ditch on WS toe.

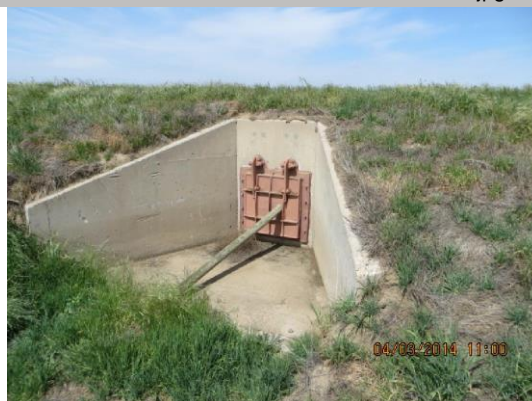
Photo 2 of 3 : UCIP\_SP\_2021\_62201\_59819.jpg

Flapgate on Concrete headwall at WS toe.

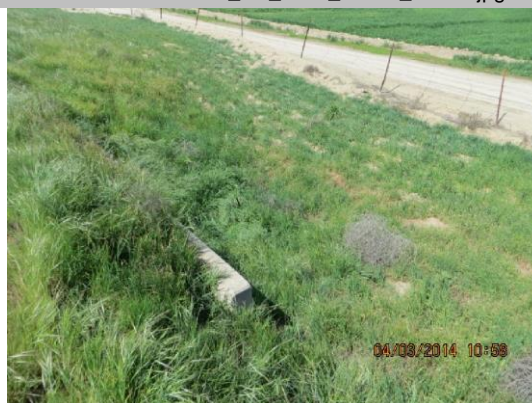
Photo 3 of 3 : UCIP\_SP\_2021\_62201\_59818.jpg

Concrete headwall on LS toe.

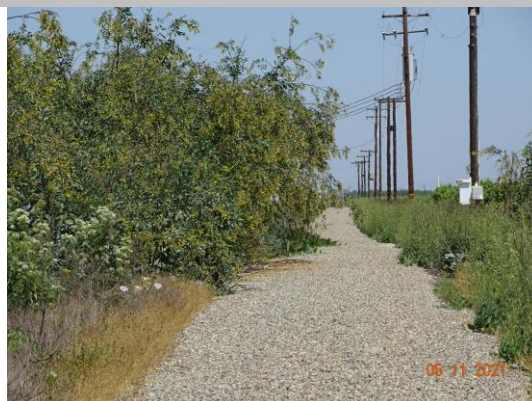
Photo 1 of 1 : SP\_2021\_NA0010\_139\_58\_20210520\_00043.jpg

LM Start	9.79	Rating **	M	Issue No.	58
LM End	9.81	Issue Type +	Ma	Location *	LS
Category	Earthen Levee			GPS Latitude/Longitude	
				Start	End
Item	Trim / Thin Trees			36.808317 °	36.808553 °
				-120.168820 °	-120.168827 °
DWR ID	DWR_NA0010_23_f_2018_58				
Comment Code					
T2 : Thin trees to allow visibility of the ground and room to flood fight.					
Inspector Comment					
Woody vegetation is partially blocking crown and landside slope.

Woody vegetation on landside toe obstructing landside of crown. (Spring 2021)

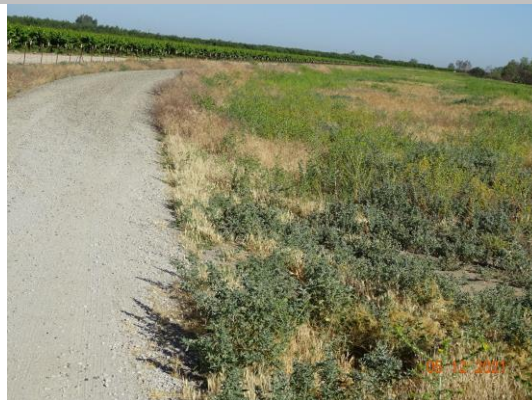
Photo 1 of 1 : SP\_2021\_NA0010\_140\_22\_20210520\_00032.jpg

LM Start	0.07	Rating **	M	Issue No.	22
LM End	7.31	Issue Type +	Ma	Location *	WS
Category	Earthen Levee			GPS Latitude/Longitude	
				Start	End
Item	Vegetation			36.772191 °	36.779554 °
				-120.284987 °	-120.199287 °
DWR ID	DWR_NA0010_24_s_2021_22				
Comment Code					
V1 : Control annual grass and weeds on the levee slopes and easements.					
Inspector Comment

View of the waterside slope looking downstream. (Spring 2021)

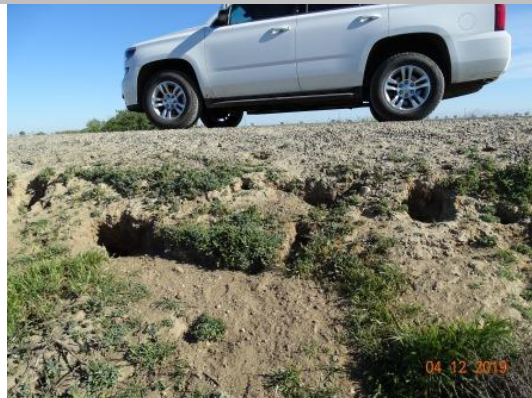
Photo 1 of 1 : SP\_2021\_NA0010\_140\_51\_20210308\_00011.jpg

LM Start	3.05	Rating **	U	Issue No.	51
LM End	3.20	Issue Type +	Ma	Location *	LS
Category	Earthen Levee			GPS Latitude/Longitude	
				Start	End
Item	Animal Control			36.770146 °	36.769796 °
				-120.245703 °	-120.243035 °
DWR ID	DWR_NA0010_24_s_2019_51				
Comment Code					
A3 : No rodents visible, but rodent burrows visible; need to backfill and compact or grout burrows.					
Inspector Comment

View of rodent holes in landside slope. (Spring 2019)

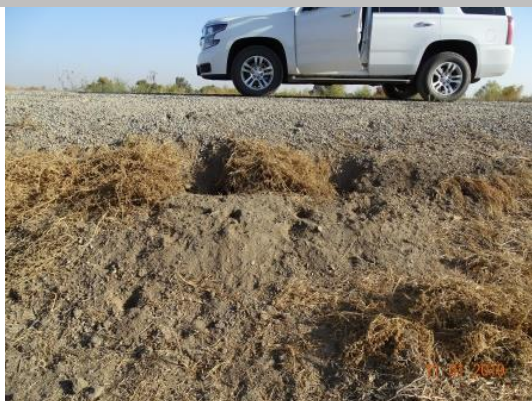
Photo 1 of 1 : SP\_2021\_NA0010\_140\_28\_20210308\_00009.jpg

LM Start	3.53	Rating **	M	Issue No.	28
LM End	3.59	Issue Type +	Ma	Location *	LS
Category	Earthen Levee			GPS Latitude/Longitude	
				Start	End
Item	Animal Control			36.768886 °	36.768531 °
				-120.237154 °	-120.236226 °
DWR ID	DWR_NA0010_24_f_2019_28				
Comment Code					
A3 : No rodents visible, but rodent burrows visible; need to backfill and compact or grout burrows.					
Inspector Comment

View of rodent burrows in the landside slope. (Fall 2019)

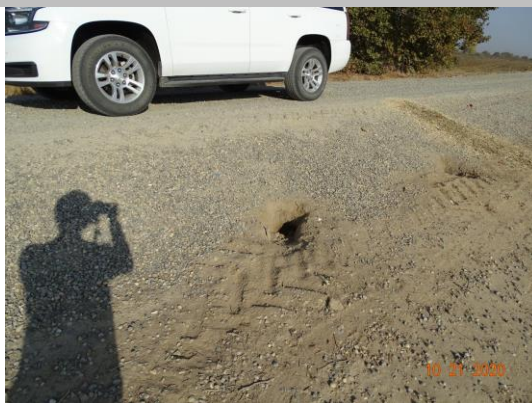
Photo 1 of 1 : SP\_2021\_NA0010\_140\_20\_20210308\_00008.jpg

LM Start	5.66	Rating **	M	Issue No.	20
LM End	5.66	Issue Type +	Ma	Location *	LS
Category	Earthen Levee			GPS Latitude/Longitude	
				Start	End
Item	Animal Control			36.784215 °	36.784215 °
				-120.218882 °	-120.218882 °
DWR ID	DWR_NA0010_24_f_2020_20				
Comment Code					
A3 : No rodents visible, but rodent burrows visible; need to backfill and compact or grout burrows.					
Inspector Comment

Rodent holes at the landside toe. (Fall 2020)

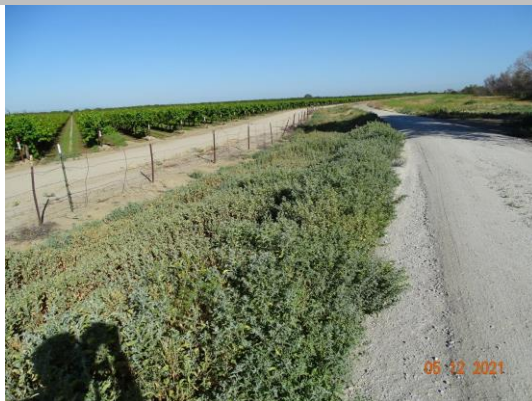
Photo 1 of 1 : SP\_2021\_NA0010\_140\_17\_20210520\_00035.jpg

LM Start	6.72	Rating **	M	Issue No.	17
LM End	7.33	Issue Type +	Ma	Location *	LS
Category	Earthen Levee			GPS Latitude/Longitude	
				Start	End
Item	Vegetation			36.786744 °	36.779355 °
				-120.204756 °	-120.199022 °
DWR ID	DWR_NA0010_24_s_2021_17				
Comment Code					
V1 : Control annual grass and weeds on the levee slopes and easements.					
Inspector Comment

View of vegetation on the landside slope looking downstream. (Spring 2021)

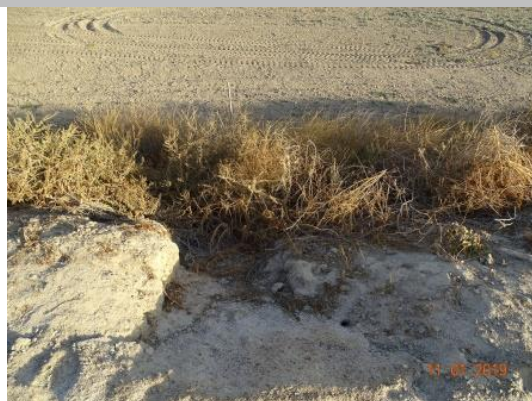
Photo 1 of 1 : SP\_2021\_NA0010\_140\_11\_20210308\_00004.jpg

LM Start	7.83	Rating **	A/W	Issue No.	11
LM End	7.83	Issue Type +	Ma	Location *	WS
Category	Earthen Levee			GPS Latitude/Longitude	
				Start	End
Item	Erosion / Bank Caving			36.775271 °	36.775271 °
				-120.192400 °	-120.192400 °
DWR ID	DWR_NA0010_24_f_2019_11				
Comment Code					
E1 : Note and monitor erosion site.					
Inspector Comment

Looking East down the waterside slope. (Fall 2019)

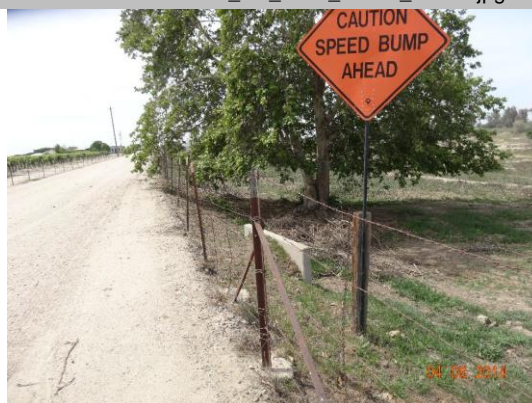
Photo 1 of 2 : UCIP\_SP\_2021\_62218\_60121.jpg

Comment Code						
Inspector Comment						
FS_ID:62218						
DS_ID:19960						
EP_NO: N/A						
Repair Type: Non-Urgent						
Crossing Status: Found						
UCIP Comments: 04/08/2014 Barbed wire along levee shoulder--no access. Need to confirm crossing size and condition of crossing. (O. Magana - DWR UCIP)						
FIELD_STRUCT_DESC: 12-inch reinforced concrete gravity drainage pipe through the levee, 3 feet below the crown. Flap gate on the waterside (WS) end. Concrete headwall on the WS end. [Additional Reference(s): DWR Levee Log, 2002 (HLM 8.33), listed as a 12-inch concrete pipe. USACE San Joaquin O&M Manual, Unit 601 Part 1 (SJR601.1), 1967, Revised 25 May 2011, (HLM 8.32), listed as a 12-inch concrete pipe]						
FS Date: 4/8/2014

View of waterward side.

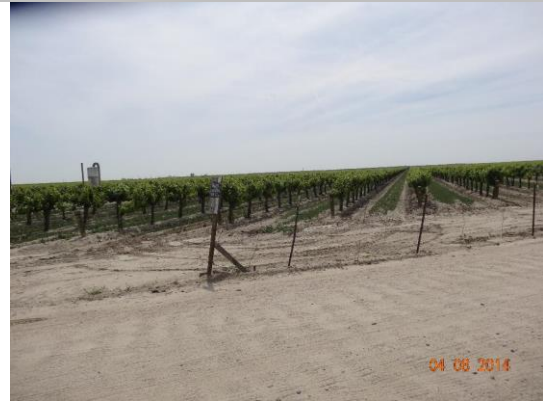
Photo 2 of 2 : UCIP\_SP\_2021\_62218\_60120.jpg

View of landward side.

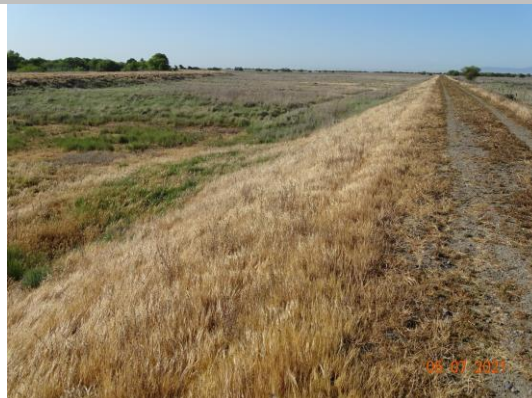
Photo 1 of 1 : SP\_2021\_NA0010\_141\_7\_20210520\_00020.jpg

LM Start	0.01	Rating **	M	Issue No.	7
LM End	2.47	Issue Type +	Ma	Location *	LS
Category	Earthen Levee			GPS Latitude/Longitude	
				Start	End
Item	Vegetation			37.296129 °	37.271355 °
				-120.880745 °	-120.866710 °
DWR ID	DWR_NA0010_25_s_2021_7				
Comment Code					
V1 : Control annual grass and weeds on the levee slopes and easements.					
Inspector Comment

View of the landside slope looking upstream. (Spring 2021)

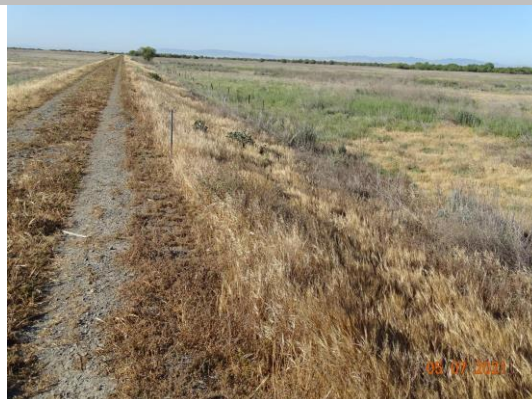
Photo 1 of 1 : SP\_2021\_NA0010\_141\_8\_20210520\_00021.jpg

LM Start	0.01	Rating **	M	Issue No.	8
LM End	2.47	Issue Type +	Ma	Location *	WS
Category	Earthen Levee			GPS Latitude/Longitude	
				Start	End
Item	Vegetation			37.296129 °	37.271347 °
				-120.880745 °	-120.866706 °
DWR ID	DWR_NA0010_25_s_2021_8				
Comment Code					
V1 : Control annual grass and weeds on the levee slopes and easements.					
Inspector Comment

View of vegetation along the waterside slope. (Spring 2021)

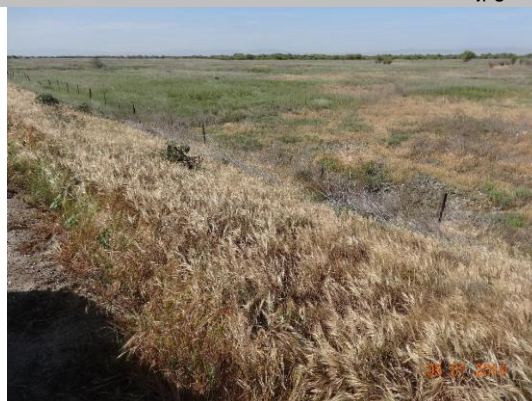
Photo 1 of 3 : UCIP\_SP\_2021\_62225\_67242.jpg

Comment Code						
Inspector Comment						
FS_ID:62225 DS_ID:19965 EP_NO: N/A Repair Type: Non-Urgent Crossing Status: Found UCIP Comments: 05/01/2014 Dense vegetation limits the inspectors visibility to identify signs of pipe failure (leaks) along the slope. Recommend removing vegetation along pipe alignment to conduct proper inspection of structure. Sediment buildup in pipe visible from landward side--recommend clearing. (O. Magana - DWR UCIP) FIELD_STRUCT_DESC: 24-inch corrugated metal gravity drainage pipe through the levee, 10 feet below the crown. Flap gate on the waterside (WS) end. [Additional Reference(s): DWR Levee Log, 2002 (HLM 0.01), listed as a 24-inch corrugated metal pipe (CMP). USACE San Joaquin O&M Manual, Unit 601 Part 1 (SJR601.1), 1967, Revised 25 May 2011, (HLM 0.02), listed as a 24-inch CMP] FS Date: 5/1/2014

View of waterward side--dense vegetation on waterward side.

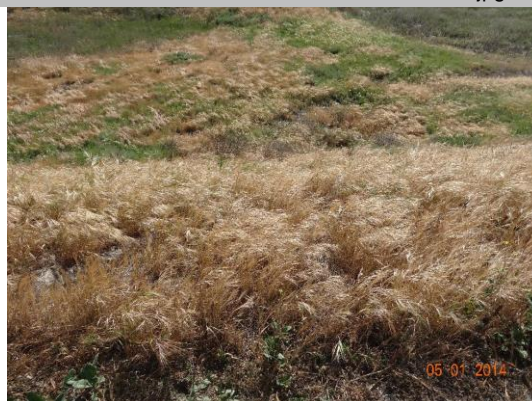
Photo 3 of 3 : UCIP\_SP\_2021\_62225\_67241.jpg

View of landward side--dense vegetation on landward side.

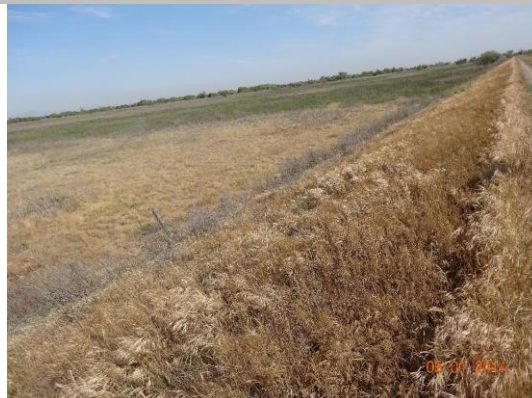
Photo 1 of 3 : UCIP\_SP\_2021\_62220\_67249.jpg

Comment Code						
Inspector Comment						
FS_ID:62220						
DS_ID:19966						
EP_NO: N/A						
Repair Type: Non-Urgent						
Crossing Status: Found						
UCIP Comments: 05/01/2014 Dense vegetation limits the inspectors visibility to identify signs of pipe failure (leaks) along the slope.						
Recommend removing vegetation along pipe alignment to conduct proper inspection of structure. (O. Magana - DWR UCIP)						
FIELD_STRUCT_DESC: 24-inch corrugated metal gravity drainage pipe through the levee, 11.6 feet below the crown. Flap gate on the waterside (WS) end. [Additional Reference(s): DWR Levee Log, 2002 (HLM 0.36), listed as a 24-inch corrugated metal pipe (CMP). USACE San Joaquin O&M Manual, Unit 601 Part 1 (SJR601.1), 1967, Revised 25 May 2011, (HLM 0.35), listed as a 24-inch CMP].						
FS Date: 5/1/2014

View of waterward side.

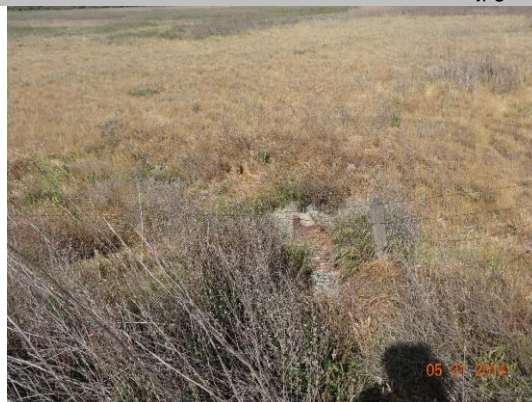
Photo 2 of 3 : UCIP\_SP\_2021\_62220\_67248.jpg

Pipe outlet visible on waterward side.

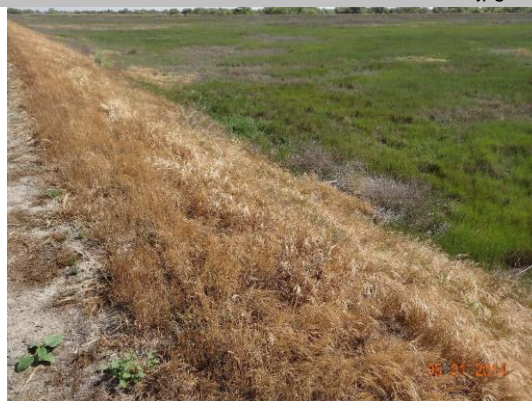
Photo 3 of 3 : UCIP\_SP\_2021\_62220\_67247.jpg

View of landward side.

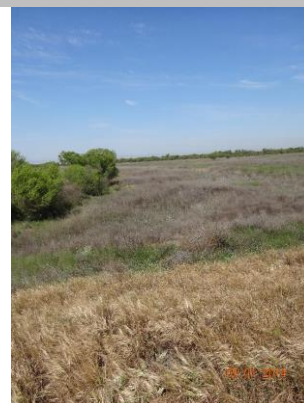
Photo 1 of 3 : UCIP\_SP\_2021\_62221\_67250.jpg

FS\_ID:62221  
DS\_ID:19967  
EP\_NO: N/A  
Repair Type: Non-Urgent  
Crossing Status: Found  
UCIP Comments: 05/01/2014 Dense vegetation limits the inspectors visibility to identify signs of pipe failure (leaks) along the slope. Recommend removing vegetation along pipe alignment to conduct proper inspection of structure. (O. Magana - DWR UCIP)  
FIELD\_STRUCT\_DESC: 24-inch corrugated metal gravity drainage pipe through the levee, 14.7 feet below the crown. Flap gate on the waterside (WS) end. [Additional Reference(s): DWR Levee Log, 2002 (HLM 0.58), listed as a 24-inch corrugated metal pipe (CMP). USACE San Joaquin O&M Manual, Unit 601 Part 1, (SJR601.1), 1967, Revised 25 May 2011, (HLM 0.59), listed as a 24-inch CMP].  
FS Date: 5/1/2014

Overview of waterward side--Salt Slough.

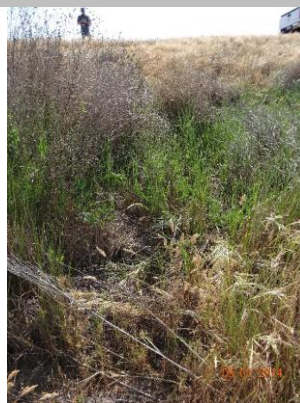
Photo 2 of 3 : UCIP\_SP\_2021\_62221\_67251.jpg

View of waterward slope covered by dense vegetation.

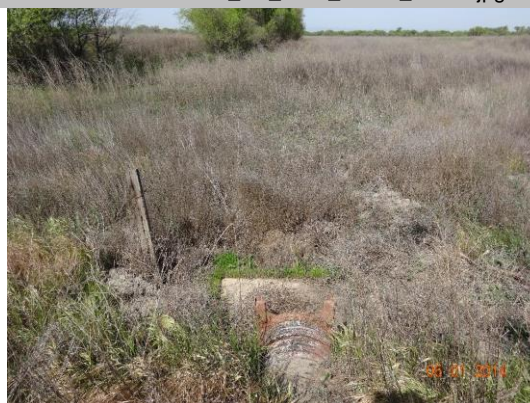
Photo 3 of 3 : UCIP\_SP\_2021\_62221\_67252.jpg

Pipe and flap gate visible on waterward side.
