**Flood Control Project Maintenance  
Levee Inspections**

## Maintenance Issue Types Only, Levee Inspection Report By Mile - Spring 2021

### Lower San Joaquin Levee District

Waterway	Bank	Unit Miles	Inspection Start/End	Inspector
Unit No. 01 San Joaquin River	Right	22.52	05/04/2021 05/04/2021	Corey Fujitani

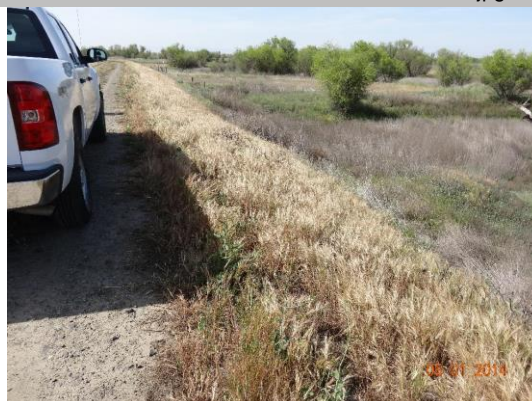
Photo 1 of 3 : UCIP\_SP\_2021\_62222\_67256.jpg

Comment Code						
Inspector Comment						
FS_ID:62222						
DS_ID:19968						
EP_NO: N/A						
Repair Type: Non-Urgent						
Crossing Status: Found						
UCIP Comments: 05/01/2014 Dense vegetation limits the inspectors visibility to identify signs of pipe failure (leaks) along the slope.						
Recommend removing vegetation along pipe alignment to conduct proper inspection of structure. (O. Magana - DWR UCIP)						
FIELD_STRUCT_DESC: 24-inch corrugated metal gravity drainage pipe through the levee, 11.4 feet below the crown. Flap gate on the waterside (WS) end. [Additional Reference(s): DWR Levee Log, 2002 (HLM 0.97), listed as a 24-inch corrugated metal pipe (CMP). USACE San Joaquin O&M Manual, Unit 601 Part 1 (SJR601.1), 1967, Revised 25 May 2011, (HLM 0.97), listed as a 24-inch CMP]						
FS Date: 5/1/2014

View of waterward side.

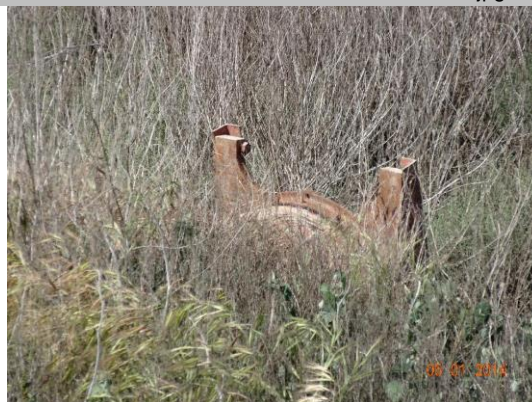
Photo 2 of 3 : UCIP\_SP\_2021\_62222\_67255.jpg

Pipe and evidence of flap gate visible on waterward side.

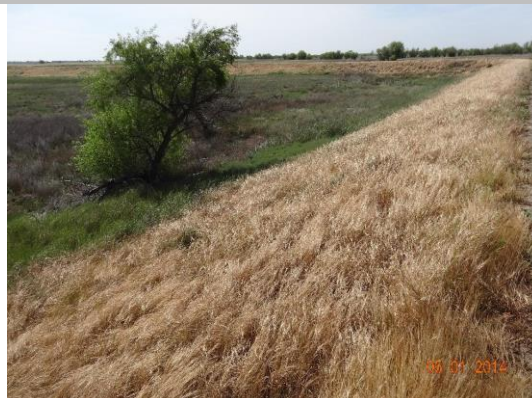
Photo 3 of 3 : UCIP\_SP\_2021\_62222\_67254.jpg

View of landward side.

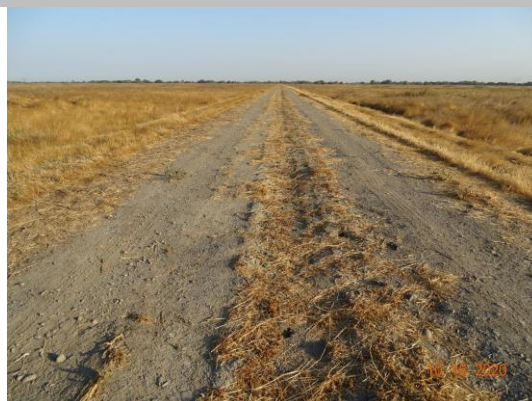
Photo 1 of 1 : SP\_2021\_NA0010\_141\_13\_20210308\_00001.jpg

LM Start	1.00	Rating **	M	Issue No.	13
LM End	2.48	Issue Type +	Ma	Location *	CR
Category	Earthen Levee			GPS Latitude/Longitude	
				Start	End
Item	Crown Surface / Depressions / Rutting			37.281791 °	37.271226 °
				-120.880747 °	-120.866655 °
DWR ID	DWR_NA0010_25_s_2018_13				
Comment Code					
C1 : Add appropriate material and re-grade the levee to bring the crown above the design elevation.					
Inspector Comment

Rutting in the levee crown. (Fall 2020)

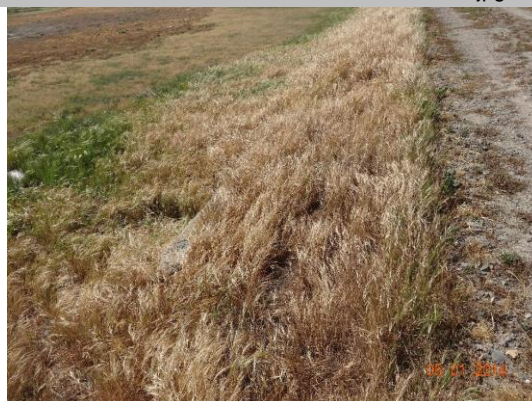
Photo 1 of 3 : UCIP\_SP\_2021\_62223\_67259.jpg

Comment Code						
Inspector Comment						
FS_ID:62223						
DS_ID:19969						
EP_NO: N/A						
Repair Type: Non-Urgent						
Crossing Status: Found						
UCIP Comments: 05/01/2014 Dense vegetation limits the inspectors visibility to identify signs of pipe failure (leaks) along the slope.						
Recommend removing vegetation along pipe alignment to conduct proper inspection of structure. (O. Magana - DWR UCIP)						
FIELD_STRUCT_DESC: 24-inch corrugated metal gravity drainage pipe through the levee, 4 feet below the crown. Flap gate on the waterside (WS) end. [Additional Reference(s): DWR Levee Log, 2002 (HLM 2.05), listed as a 24-inch corrugated metal pipe (CMP). USACE San Joaquin O&M Manual, Unit 601 Part 1 (SJR601.1), 1967, Revised 25 May 2011, (HLM 2.05), listed as a 24-inch CMP]						
FS Date: 5/1/2014

View of landward side.

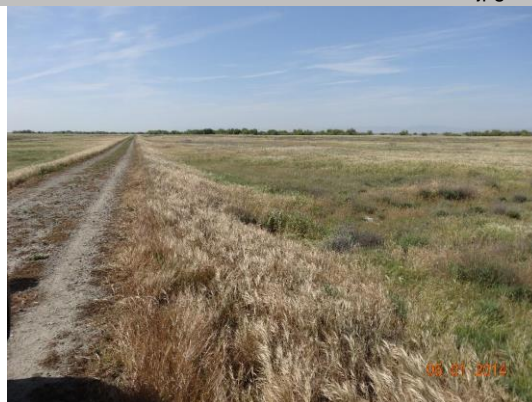
Photo 2 of 3 : UCIP\_SP\_2021\_62223\_67260.jpg

View of waterward side.

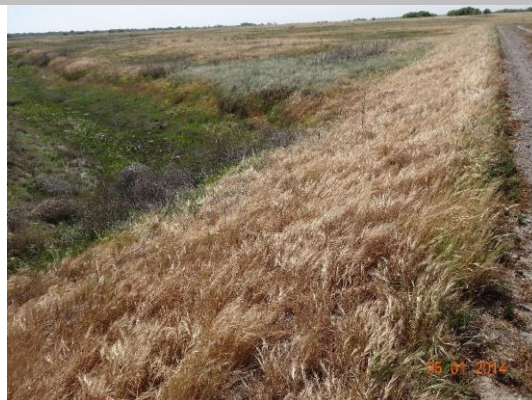
Photo 3 of 3 : UCIP\_SP\_2021\_62224\_67268.jpg

View of landward side.
