**Flood Control Project Maintenance
Levee Inspections**

Maintenance Issue Types Only, Levee Inspection Report By Mile - Spring 2022

Lower San Joaquin Levee District

Waterway	Bank	Unit Miles	Inspection Start/End	Inspector
Unit No. 01 San Joaquin River	Right	22.52	04/05/2022 04/05/2022	Corey Fujitani

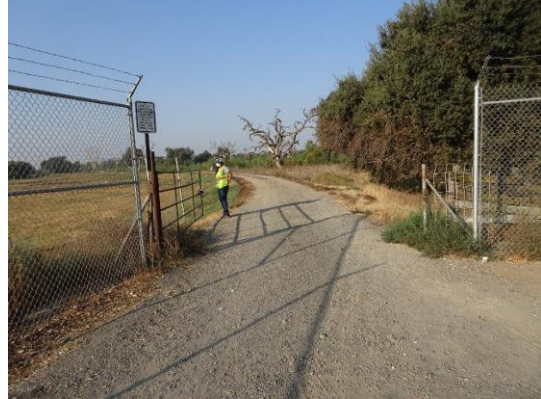
Photo 1 of 3 : UCIP_SP_2022_70636_92086.jpg

Comment Code						
Inspector Comment						
FS_ID:70636 DS_ID:19650 EP_NO: N/A Repair Type: Non-Urgent Crossing Status: Found UCIP Comments: 10/06/2020 Record remains Non-Urgent. DWR DMP has found integrity issues, LOF between 4 and 5. This crossing will be monitored until funding becomes available for rehabilitation. Dense vegetation was found along the LS and WS. No permit was found authorizing this encroachment. The CVFPB will need to review crossing to determine owner. (O. Magana - DWR UCIP, B. Singh - GEI)04/08/2014 Dense vegetation limits the inspector's visibility to identify signs of pipe failure (leaks) along the waterward slope and landward toe. Recommend removing vegetation along pipe alignment and landward toe to conduct proper inspection of structure and appurtenances. (W. Wylie - DWR UCIP) FIELD_STRUCT_DESC: 24-inch corrugated metal (CM) gravity drainage pipe through the levee, 10.5 feet below the crown. Flap gate on the waterside (WS) end. Brass cap No. 108 bench mark (BM) on the headwall on the landside (LS), elevation 65.1 feet, USGS Datum. [Additional Reference(s): DWR Levee Log, 2002, (HLM 0.00). USACE San Joaquin O&M Manual, Unit No. 601, Part No. 1, (SJR601.1), 1967, Revised 25 May 2011, (HLM 0.02)]. FS Date: 10/6/2020

Overview of levee crown looking upstream towards pipe crossing. Pipe is located near gate entrance.

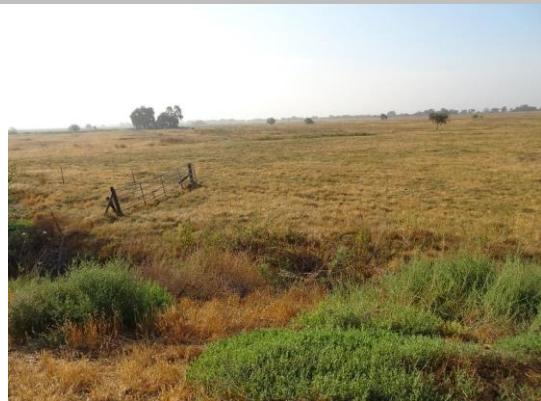
Photo 2 of 3 : UCIP_SP_2022_70636_92088.jpg

LS view: overview of LS, dense vegetation on slope and levee toe.

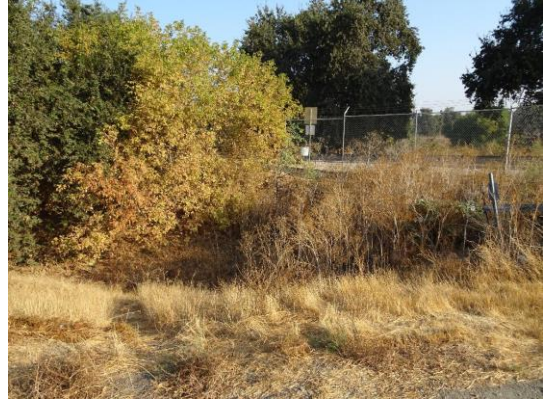
Photo 3 of 3 : UCIP_SP_2022_70636_92087.jpg

WS view: overview of WS, dense vegetation on slope and levee toe.

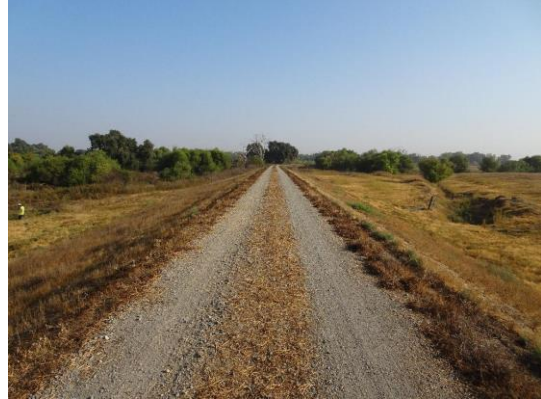
Photo 1 of 3 : UCIP_SP_2022_70637_90529.jpg

Comment Code					
Inspector Comment					
FS_ID:70637 DS_ID:19651 EP_NO: N/A Repair Type: Non-Urgent Crossing Status: Found UCIP Comments: 10/06/2020 Record remains Non-Urgent. No permit was found authorizing this encroachment. Sediment buildup found on the LS. Recommend maintenance to clear up sediment buildup along pipe invert. CVFPB will need to review crossing to determine owner. DWR DMP internal inspection is pending and scheduled for 2021. (O. Magana - DWR UCIP, B. Singh - GEI)04/08/2014 Pipe has significant sediment buildup and shows some signs of corrosion at landward toe. Recommend cleaning sediment from inside pipe and check wall integrity. (W. Wylie - DWR UCIP) FIELD_STRUCT_DESC: 36-inch corrugated metal (CM) gravity drainage pipe through the levee, 18.5 feet below the crown. Flap gate on the waterside (WS) end. Brass cap No. 108 bench mark (BM) on the headwall on the landside (LS). [Additional Reference(s): DWR Levee Log, 2002, (HLM 0.35). USACE San Joaquin O&M Manual, Unit No. 601, Part No. 1, (SJR601.1), 1967, Revised 25 May 2011, (HLM 0.35)]. FS Date: 10/6/2020

Overview of levee looking US

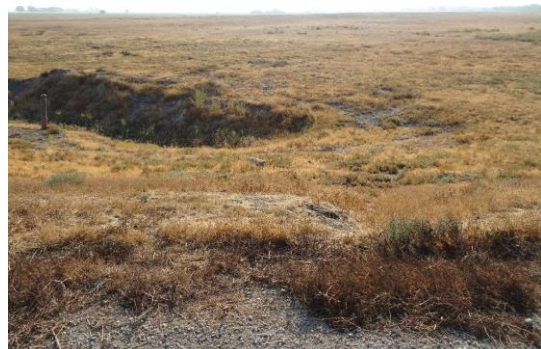
Photo 2 of 3 : UCIP_SP_2022_70637_90530.jpg

LS view: Overview of LS from levee crest, looking US

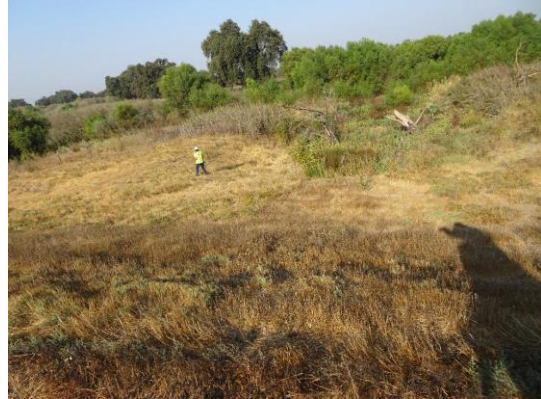
Photo 3 of 3 : UCIP_SP_2022_70637_90531.jpg

WS view: Overview of WS slope, looking US

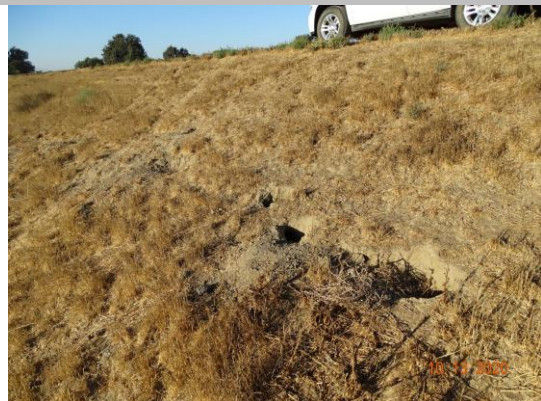
Photo 1 of 1 : SP_2022_NA0010_118_95_20220308_00006.jpg

LM Start	0.36	Rating **	M	Issue No.	95
LM End	0.36	Issue Type +	Ma	Location *	LS
Category	Earthen Levee			GPS Latitude/Longitude	
				Start	End
Item	Animal Control			37.344312 °	37.344312 °
				-120.962361 °	-120.962361 °
DWR ID	DWR_NA0010_01_f _ 2020_95				
Comment Code					
A3 : No rodents visible, but rodent burrows visible; need to backfill and compact or grout burrows.					
Inspector Comment

Several rodent holes observed in the landside slope. (Fall 2020)

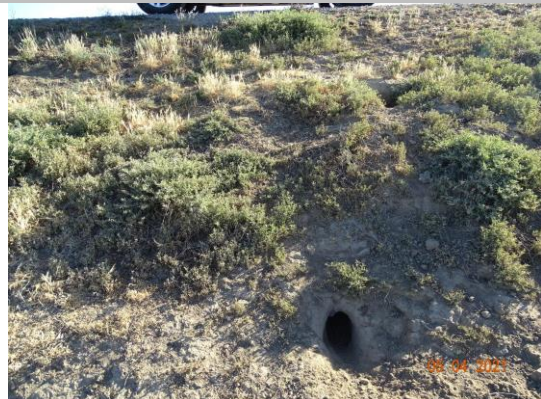
Photo 1 of 1 : SP_2022_NA0010_118_97_20220308_00007.jpg

LM Start	0.45	Rating **	M	Issue No.	97
LM End	0.45	Issue Type +	Ma	Location *	WS
Category	Earthen Levee			GPS Latitude/Longitude	
				Start	End
Item	Animal Control			37.343243 °	37.343243 °
				-120.962159 °	-120.962159 °
DWR ID	DWR_NA0010_01_s_2021_97				
Comment Code					
A1 : Exterminate rodents and backfill and compact or grout burrows.					
Inspector Comment

View of rodent burrows in the waterside slope. (Spring 2021)

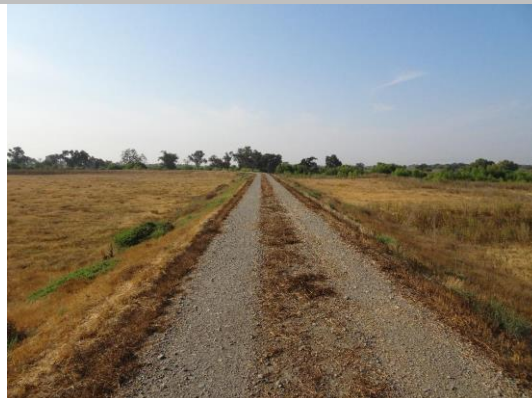
Photo 1 of 3 : UCIP_SP_2022_70638_90537.jpg

Comment Code						
Inspector Comment						
FS_ID:70638 DS_ID:19583 EP_NO: N/A Repair Type: Non-Urgent Crossing Status: Found UCIP Comments: 10/06/2020 Record remains Non-Urgent. No permit was found authorizing this encroachment. Rodent activity found near pipe location. CVFPB will need to review crossing to determine owner. DWR DMP has not found internal issues, LOF between 1 and 2. Recommend inspection in 5 years. (B. Singh - GEI, O. Magana - DWR UCIP)04/08/2014 Recommend removing vegetation pile from waterward toe. (W. Wylie - DWR UCIP) FIELD_STRUCT_DESC: 24-inch corrugated metal (CM) gravity drainage pipe through the levee, 8.5 feet below the crown. Flap gate on the waterside (WS) end. Brass cap No. 108 bench mark (BM) on the headwall on the landside (LS). [Additional Reference(s): DWR Levee Log, 2002, (HLM 0.62). USACE San Joaquin O&M Manual, Unit No. 601, Part No. 1, (SJR601.1), 1967, Revised 25 May 2011, (HLM 0.62)]. FS Date: 10/6/2020

Overview of levee crown, looking US

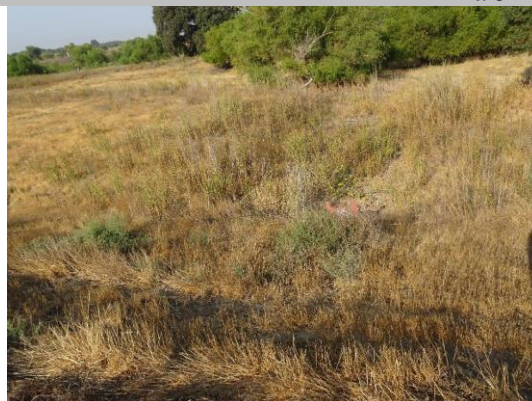
Photo 2 of 3 : UCIP_SP_2022_70638_90538.jpg

WS view: Flapgate and pipe visible on WS toe

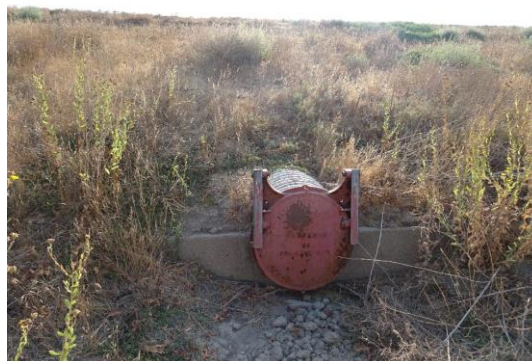
Photo 3 of 3 : UCIP_SP_2022_70638_90535.jpg

WS view: Flapgate and headwall at WS toe

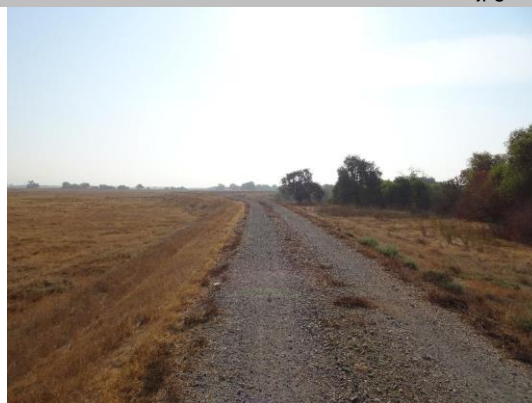
Photo 1 of 3 : UCIP_SP_2022_70639_90541.jpg

Overview of levee crown, looking US

Comment Code					
Inspector Comment					
FS_ID:70639 DS_ID:19584 EP_NO: N/A Repair Type: Non-Urgent Crossing Status: Found UCIP Comments: 10/06/2020 Record has been updated from No Action Needed to Non-Urgent. No permit was found authorizing this encroachment. CVFPB will need to review crossing to determine owner. Rodent activity found near this stretch of levee. DWR DMP has not found internal issues, LOF between 1 and 2. Recommend inspection in 5 years. (B. Singh - GEI, O. Magana - DWR UCIP) FIELD_STRUCT_DESC: 24-inch corrugated metal (CM) gravity drainage pipe through the levee, 7.0 feet below the crown. Flap gate on the waterside (WS) end. Brass cap No. 108 bench mark (BM) on the headwall on the landside (LS). [Additional Reference(s): DWR Levee Log, 2002, (HLM 0.88). USACE San Joaquin O&M Manual, Unit No. 601, Part No. 1, (SJR601.1), 1967, Revised 25 May 2011, (HLM 0.87)]. FS Date: 10/6/2020

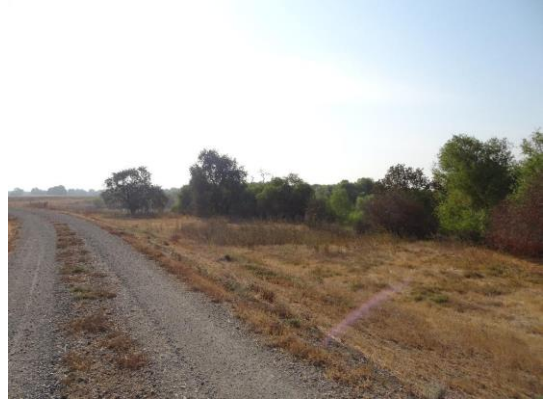
Photo 2 of 3 : UCIP_SP_2022_70639_92306.jpg

WS view: overview of WS looking upstream towards pipe crossing.

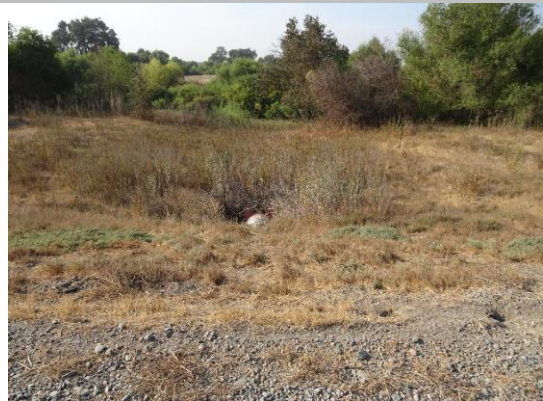
Photo 3 of 3 : UCIP_SP_2022_70639_90542.jpg

WS view: Flapgate and pipe visible on WS toe

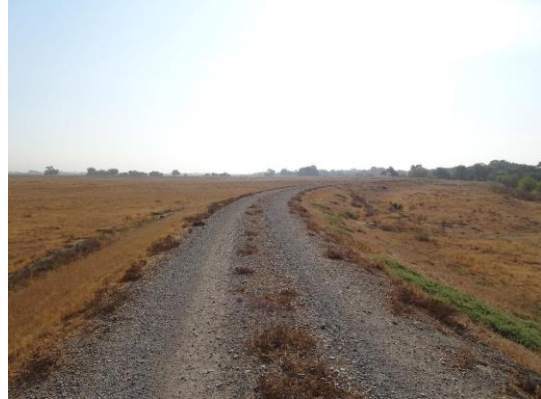
Photo 1 of 3 : UCIP_SP_2022_70640_90550.jpg

Comment Code					
Inspector Comment					
FS_ID:70640 DS_ID:19585 EP_NO: N/A Repair Type: Urgent Crossing Status: Found UCIP Comments: 10/06/2020 Record has been updated from Non-Urgent to Urgent. DWR DMP has found integrity issues, LOF between 5 and 6. Scour visible behind the concrete headwall on the LS toe. Recommend monitoring crossing until funding becomes available to addressed. No permit was found authorizing this encroachment. CVFPB will need to review crossing to determine owner. (B. Singh - GEI, O. Magana - DWR UCIP)04/08/2014 Moderate erosion around headwall on landward toe. May or may not be an issue. Need to contact owner to determine status of crossing and to address erosion issue on landward side. (W. Wylie - DWR UCIP) FIELD_STRUCT_DESC: 24-inch corrugated metal (CM) gravity drainage pipe through the levee, 9.0 feet below the crown. Flap gate on the waterside (WS) end. Brass cap No. 108 bench mark (BM) on the headwall on the landside (LS). [Additional Reference(s): DWR Levee Log, 2002, (HLM 0.96). USACE San Joaquin O&M Manual, Unit No. 601, Part No. 1, (SJR601.1), 1967, Revised 25 May 2011, (HLM 0.95)]. FS Date: 10/6/2020

Overview of levee crown, looking US

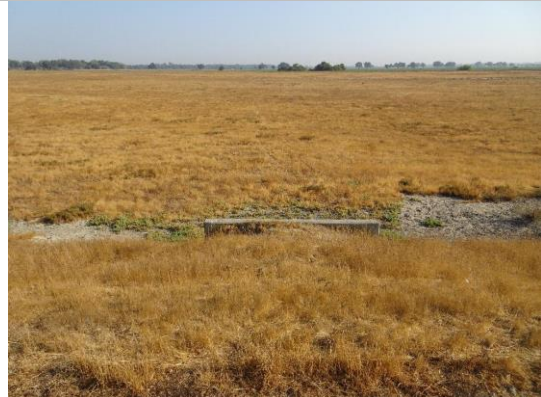
Photo 2 of 3 : UCIP_SP_2022_70640_90552.jpg

LS view: Headwall visible on LS toe

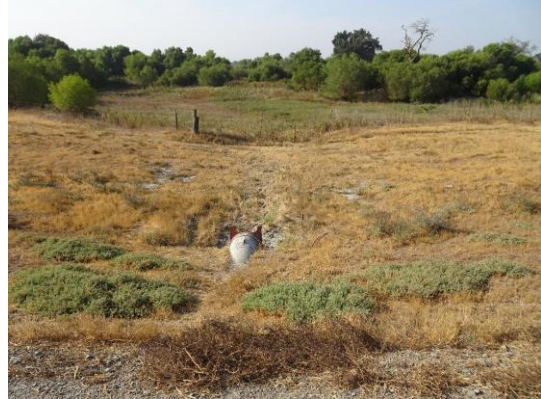
Photo 3 of 3 : UCIP_SP_2022_70640_90551.jpg

WS view: Flapgate, headwall, and pipe visible on WS toe

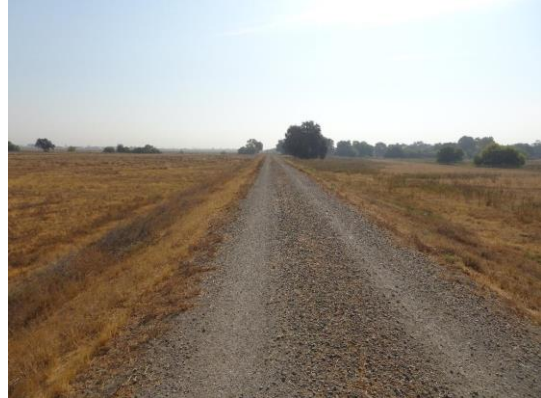
Photo 1 of 3 : UCIP_SP_2022_70641_90554.jpg

FS_ID:70641
 DS_ID:19586
 EP_NO: N/A
 Repair Type: Non-Urgent
 Crossing Status: Found
 UCIP Comments: 10/06/2020 Record has been updated from No Action Needed to Non-Urgent. No permit was found authorizing this encroachment. CVFPB will need to review crossing to determine owner. DWR DMP has not found internal issues, LOF between 1 and 2. Recommend inspection in 5 years. (B. Singh - GEI, O. Magana - DWR UCIP)
 FIELD_STRUCT_DESC: 24-inch corrugated metal (CM) gravity drainage pipe through the levee, 7.5 feet below the crown. Flap gate on the waterside (WS) end. Brass cap No. 108 bench mark (BM) on the headwall on the landside (LS). [Additional Reference(s): DWR Levee Log, 2002, (HLM 1.18). USACE San Joaquin O&M Manual, Unit No. 601, Part No. 1, (SJR601.1), 1967, Revised 25 May 2011, (HLM 1.17)].
 FS Date: 10/6/2020

Overview of levee crown, looking US

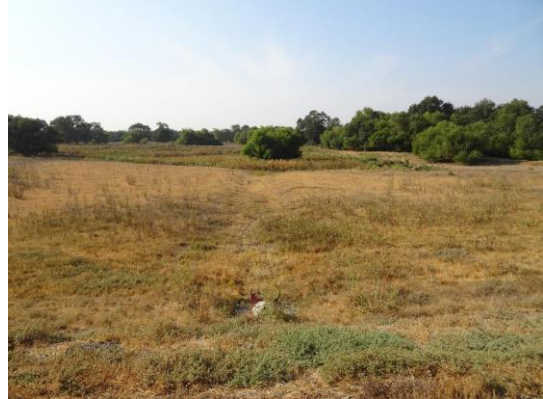
Photo 2 of 3 : UCIP_SP_2022_70641_90555.jpg

Pipe and flapgate visible on WS toe

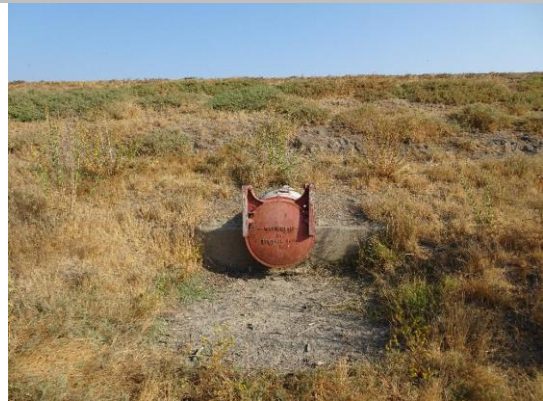
Photo 3 of 3 : UCIP_SP_2022_70641_90553.jpg

Pipe, flapgate and headwall on WS toe

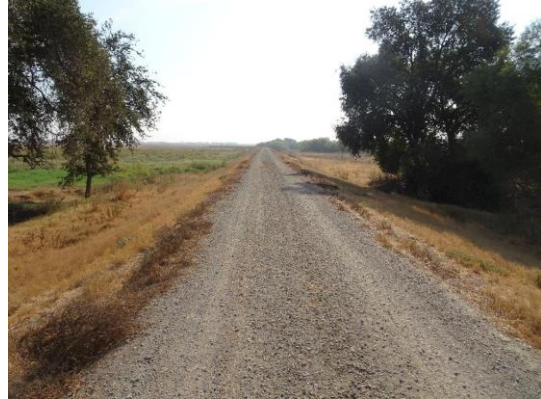
Photo 1 of 3 : UCIP_SP_2022_70642_90560.jpg

Comment Code					
Inspector Comment					
FS_ID:70642 DS_ID:19587 EP_NO: N/A Repair Type: Non-Urgent Crossing Status: Found UCIP Comments: 10/06/2020 Record has been updated from No Action Needed to Non-Urgent. No permit was found authorizing this encroachment. CVFPB will need to review crossing to determine owner. DWR DMP internal inspection is still pending and scheduled for 2021. (B. Singh - GEI, O. Magana - DWR UCIP) FIELD_STRUCT_DESC: 36-inch corrugated metal (CM) gravity drainage pipe through the levee, 12.8 feet below the crown. Flap gate on the waterside (WS) end. Brass cap No. 108 bench mark (BM) on the headwall on the landside (LS). Pipe crosses through the levee at about a 45-degree angle. [Additional Reference(s): DWR Levee Log, 2002, (HLM 1.35). USACE San Joaquin O&M Manual, Unit No. 601, Part No. 1, (SJR601.1), 1967, Revised 25 May 2011, (HLM 1.34)]. FS Date: 10/6/2020

Overview of levee crown, looking US

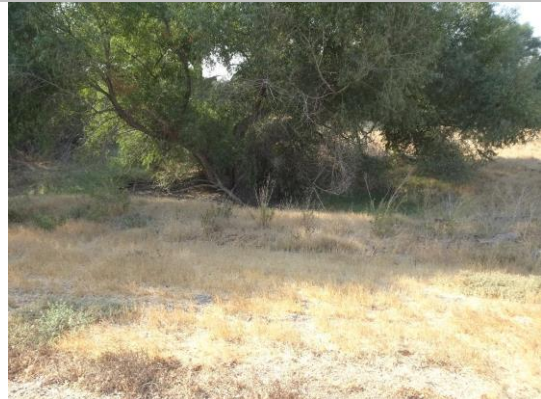
Photo 2 of 3 : UCIP_SP_2022_70642_90565.jpg

WS view: Overview of WS from levee crown. Headwall not visible from levee crown

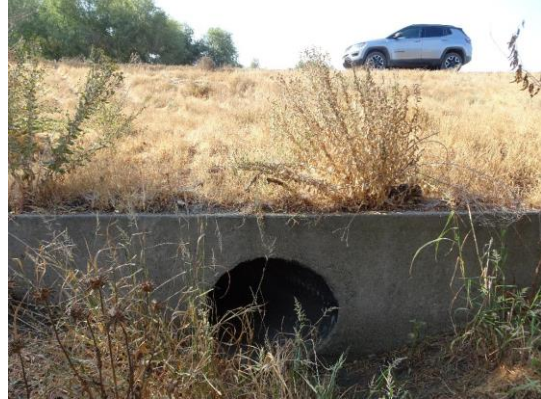
Photo 3 of 3 : UCIP_SP_2022_70642_90561.jpg

LS view: Concrete headwall and pipe visible at LS toe

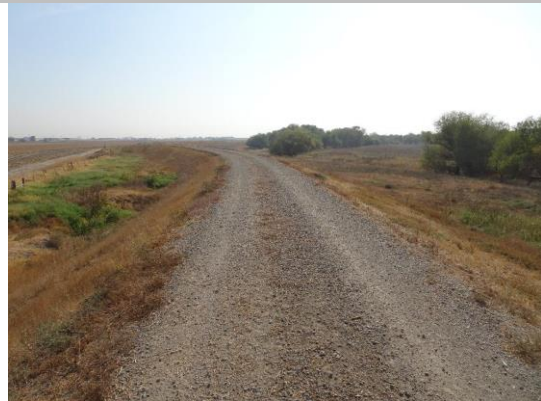
Photo 1 of 3 : UCIP_SP_2022_70643_90567.jpg

FS_ID:70643
DS_ID:19588
EP_NO: N/A
Repair Type: Non-Urgent
Crossing Status: Found
UCIP Comments: 10/06/2020 Record remains Non-Urgent. No permit was found authorizing this encroachment. CVFPB will need to review crossing to determine owner. DWR DMP has not found internal issues, LOF between 1 and 2. Recommend inspection in 5 years. (B. Singh - GEI, O. Magana - DWR UCIP)04/08/2014 Some sediment buildup inside pipe at LS toe. Recommend contacting owner to clear sediment buildup and check wall integrity through pipe section. (W. Wylie - DWR UCIP)
FIELD_STRUCT_DESC: 24-inch corrugated metal (CM) gravity drainage pipe through the levee, 11.0 feet below the crown. Flap gate on the waterside (WS) end. Brass cap No. 108 bench mark (BM) on the headwall on the landside (LS). [Additional Reference(s): DWR Levee Log, 2002, (HLM 1.48). USACE San Joaquin O&M Manual, Unit No. 601, Part No. 1, (SJR601.1), 1967, Revised 25 May 2011, (HLM 1.48)].

Overview of levee crown, looking US

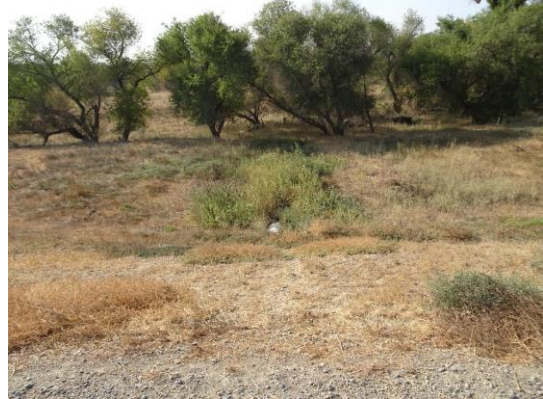
Photo 2 of 3 : UCIP_SP_2022_70643_90568.jpg

Pipe and flapgate visible on WS toe

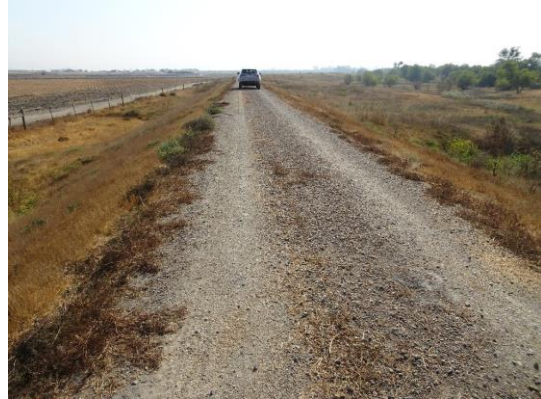
Photo 1 of 3 : UCIP_SP_2022_70644_90572.jpg

Comment Code					
Inspector Comment					
FS_ID:70644 DS_ID:19589 EP_NO: N/A Repair Type: Non-Urgent Crossing Status: Found UCIP Comments: 10/06/2020 Record remains Non-Urgent. DWR DMP has found integrity issues, LOF between 4 and 5. Crossing will be monitored until funding becomes available for rehabilitation. No permit was found authorizing this encroachment. CVFPB will need to review crossing to determine owner. Dense vegetation was found along the WS and LS toe. Recommend removing vegetation along the pipe alignment. Based on the 2014 photos, the LS toe appears to be heavily silted up. Recommend removing silt to increase flow capacity and meet pipe design capacity. (B. Singh - GEI, O. Magana - DWR UCIP)04/08/2014 Heavy sediment buildup in pipe at LS toe. (DWR UCIP - W. Wylie) FIELD_STRUCT_DESC: 24-inch corrugated metal (CM) gravity drainage pipe through the levee, 13.6 feet below the crown. Flap gate on the waterside (WS) end. Brass cap No. 108 bench mark (BM) on the headwall on the landside (LS). [Additional Reference(s): DWR Levee Log, 2002, (HLM 1.70). USACE San Joaquin O&M Manual, Unit No. 601, Part No. 1, (SJR601.1), 1967, Revised 25 May 2011, (HLM 1.69)]. FS Date: 10/6/2020

Overview of levee crown, looking US

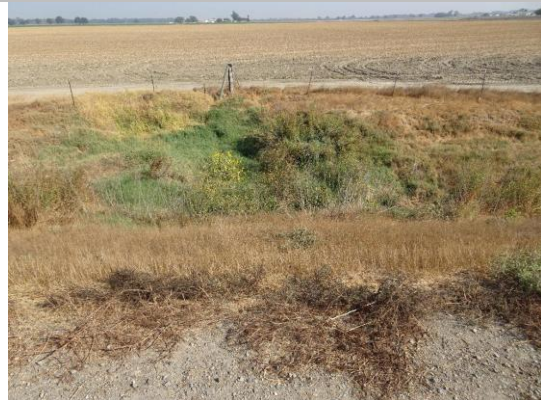
Photo 2 of 3 : UCIP_SP_2022_70644_90573.jpg

LS view: Pipe and headwall not visible on LS toe from levee crown

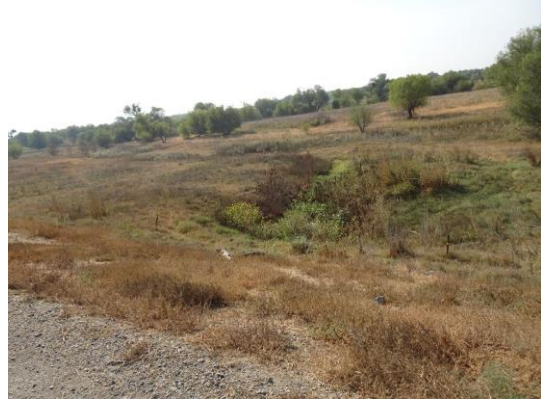
Photo 3 of 3 : UCIP_SP_2022_70644_90574.jpg

WS view: Flapgate and headwall not visible on WS toe from levee crown

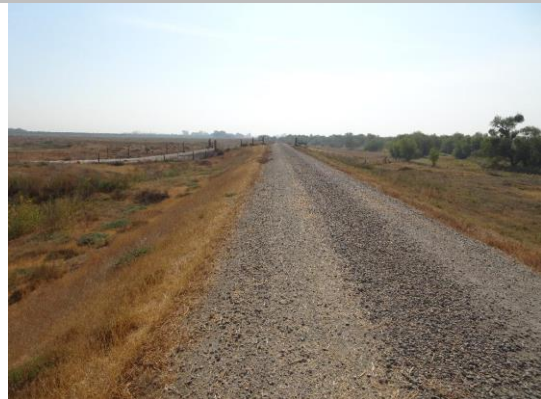
Photo 1 of 3 : UCIP_SP_2022_70645_90581.jpg

Overview of levee crown, looking upstream

Comment Code					
Inspector Comment					
FS_ID:70645 DS_ID:19590 EP_NO: N/A Repair Type: Non-Urgent Crossing Status: Found UCIP Comments: 10/06/2020 Record has been updated from No Action Needed to Non-Urgent. No permit was found authorizing this encroachment. CVFPB will need to review crossing to determine owner. DWR DMP internal inspection is pending and scheduled for 2021. Dense vegetation was observed along the pipe alignment and both WS and LS toe. Recommend clearing vegetation along pipe alignment. (B. Singh - GEI, O. Magana - DWR UCIP) FIELD_STRUCT_DESC: 36-inch corrugated metal (CM) gravity drainage pipe through the levee, 14.2 feet below the crown. Flap gate on the waterside (WS) end. Brass cap No. 100 bench mark (BM) on the headwall on the landside (LS). [Additional Reference(s): DWR Levee Log, 2002, (HLM 1.84). USACE San Joaquin O&M Manual, Unit No. 601, Part No. 1, (SJR601.1), 1967, Revised 25 May 2011, (HLM 1.83)]. FS Date: 10/6/2020

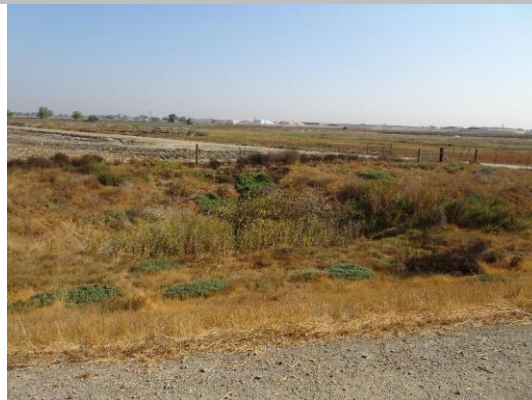
Photo 2 of 3 : UCIP_SP_2022_70645_90583.jpg

LS view: Pipe and headwall are not visible at LS toe from levee crown

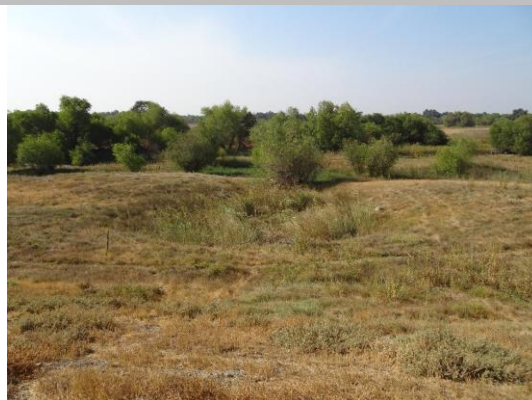
Photo 3 of 3 : UCIP_SP_2022_70645_90582.jpg

WS view: Pipe, flapgate, and headwall are not visible at WS toe from levee crown

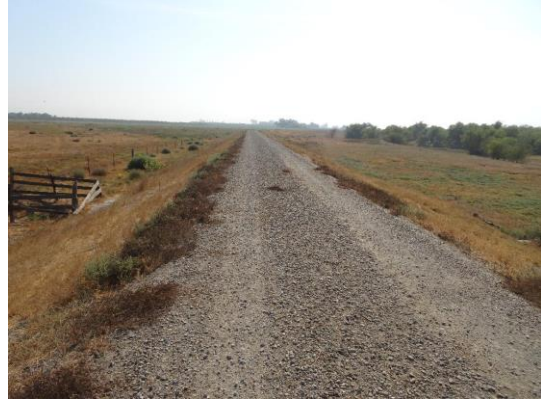
Photo 1 of 3 : UCIP_SP_2022_70646_90611.jpg

Comment Code						
Inspector Comment						
FS_ID:70646 DS_ID:19591 EP_NO: N/A Repair Type: Non-Urgent Crossing Status: Found UCIP Comments: 10/06/2020 Record remains Non-Urgent. Rodent activity found in the general area. No permit was found authorizing this encroachment. CVFPB will need to review crossing to determine owner. DWR DMP has not found internal issues, LOF between 1 and 2. Recommend inspection in 5 years. (B. Singh - GEI, O. Magana - DWR UCIP)04/08/2014 Need to contact owner to determine crossing status. Inlet drop box silted in and needs to be cleaned out. (W. Wylie - DWR UCIP) FIELD_STRUCT_DESC: 24-inch corrugated metal (CM) gravity drainage pipe through the levee, 9.7 feet below the crown. Flap gate on the waterside (WS) end. Brass cap No. 100 bench mark (BM) on the headwall on the landside (LS). Wooden barrier around drop inlet on the LS toe. [Additional Reference(s): DWR Levee Log, 2002, (HLM 1.98). USACE San Joaquin O&M Manual, Unit No. 601, Part No. 1, (SJR601.1), 1967, Revised 25 May 2011, (HLM 1.98)]. FS Date: 10/6/2020

Overview of levee crown, looking US

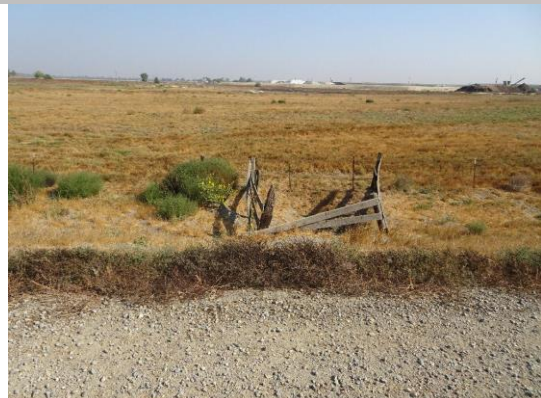
Photo 2 of 3 : UCIP_SP_2022_70646_90613.jpg

LS view: View toward LS pipe and headwall from levee crown

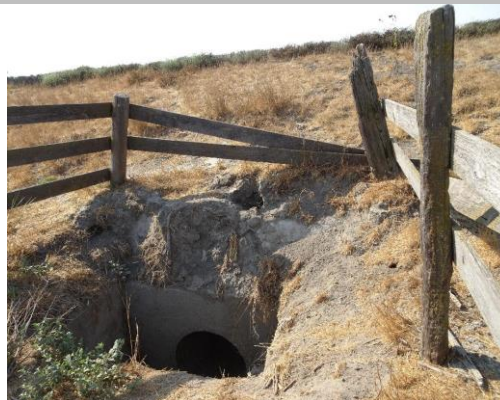
Photo 3 of 3 : UCIP_SP_2022_70646_90615.jpg

LS view: Pipe and headwall at LS toe

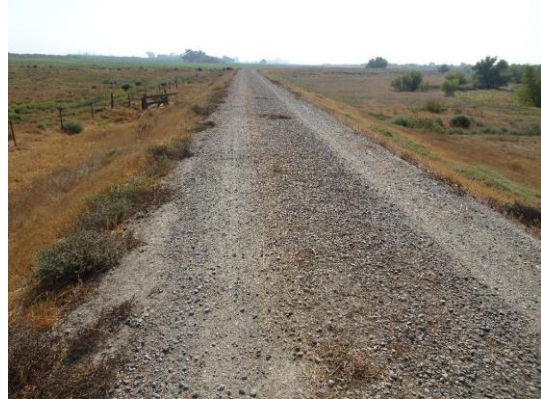
Photo 1 of 3 : UCIP_SP_2022_70647_90617.jpg

Comment Code						
Inspector Comment						
FS_ID:70647 DS_ID:19570 EP_NO: N/A Repair Type: Urgent Crossing Status: Found UCIP Comments: 10/06/2020 Record updated from Non-Urgent to Urgent. DMP internal video inspection has found pipe integrity issues. LOF of crossing is between 5 and 6. Crossing will be monitored until funding becomes available to address the issues. Wooden barrier surrounding drop-inlet is dilapidated. No permit was found authorizing this encroachment. CVFPB will need to review crossing to determine owner. (B. Singh - GEI, O. Magana - DWR UCIP) 04/08/2014 Unable to find inlet on landward toe. Recommend clearing vegetation on landward side to properly inspect inlet. (W. Wylie - DWR UCIP) FIELD_STRUCT_DESC: 24-inch corrugated metal (CM) gravity drainage pipe through the levee, 9.8 feet below the crown. Flap gate on the waterside (WS) end. Brass cap No. 100 bench mark (BM) on the headwall on the landside (LS). [Additional Reference(s): DWR Levee Log, 2002, (HLM 2.08). USACE San Joaquin O&M Manual, Unit No. 601, Part No. 1, (SJR601.1), 1967, Revised 25 May 2011, (HLM 2.08)]. FS Date: 10/6/2020

Overview of levee crown, looking US

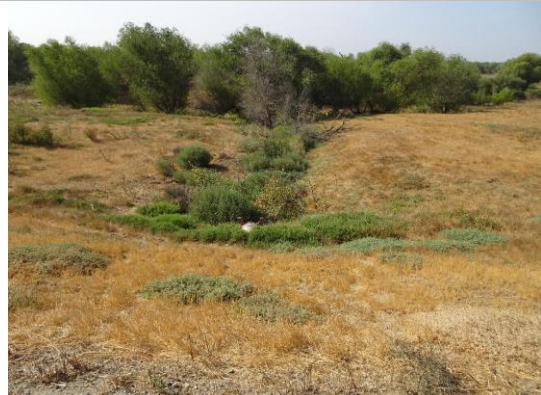
Photo 2 of 3 : UCIP_SP_2022_70647_90618.jpg

WS view: Pipe and flapgate visible on WS toe

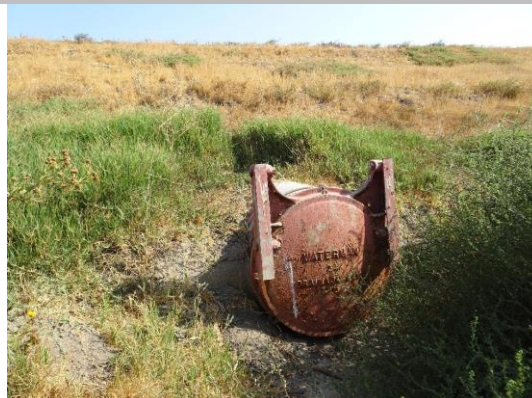
Photo 3 of 3 : UCIP_SP_2022_70647_90620.jpg

WS view: Pipe, flapgate, and headwall on WS toe

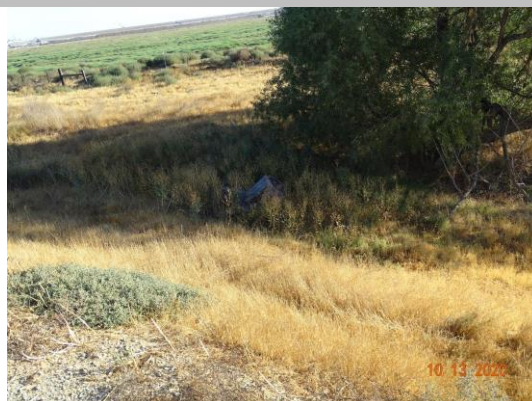
Photo 1 of 1 : SP_2022_NA0010_118_110_20220308_00013.jpg

LM Start	2.20	Rating **	N	Issue No.	110
LM End	2.20	Issue Type +	Ma	Location *	LS
Category	Earthen Levee			GPS Latitude/Longitude	
				Start	End
Item	Trim / Thin Trees			37.331820 °	37.331820 °
				-120.937605 °	-120.937605 °
DWR ID	DWR_NA0010_01_f_2018_110				
Comment Code					
T5 : Tree stumps.					
Inspector Comment					
Tree stump on landside slope should be removed.

View of tree stump on the landside slope. (Fall 2020)

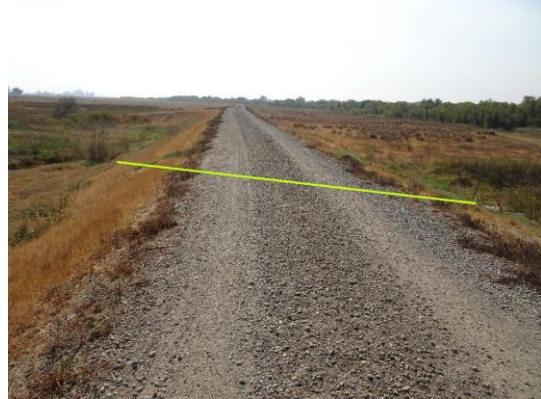
Photo 1 of 3 : UCIP_SP_2022_70648_90625.jpg

Comment Code					
Inspector Comment					
FS_ID:70648 DS_ID:19571 EP_NO: N/A Repair Type: Non-Urgent Crossing Status: Found UCIP Comments: 10/06/2020 Record has been updated from No Action Needed to Non-Urget. Pipe angle through the levee. System description has been updated. No permit was found authorizing this encroachment. CVFPB will need to review crossing to determine owner. DWR DMP internal inspection is pending and scheduled for 2021. (B. Singh - GEI, O. Magana - DWR UCIP) FIELD_STRUCT_DESC: 36-inch corrugated metal (CM) gravity drainage pipe through the levee at an angle, 12.6 feet below the crown. Flap gate on the waterside (WS) end. Brass cap No. 100 bench mark (BM) on the headwall on the landside (LS). Wooden barrier around drop inlet on the LS toe. [Additional Reference(s): DWR Levee Log, 2002, (HLM 2.25). USACE San Joaquin O&M Manual, Unit No. 601, Part No. 1, (SJR601.1), 1967, Revised 25 May 2011, (HLM 2.25)]. FS Date: 10/6/2020

Overview of levee crown, looking US. Pipe angled through levee at alignment shown

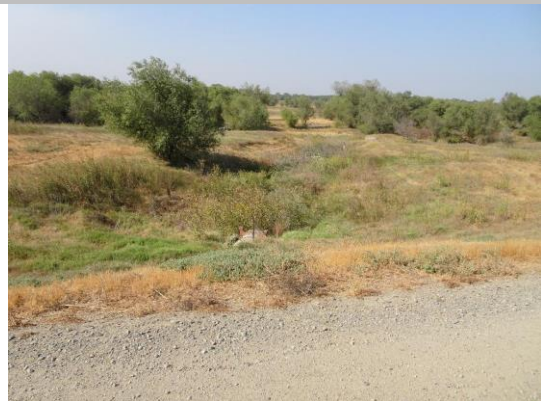
Photo 2 of 3 : UCIP_SP_2022_70648_90626.jpg

WS view: Pipe and flapgate visible on WS toe

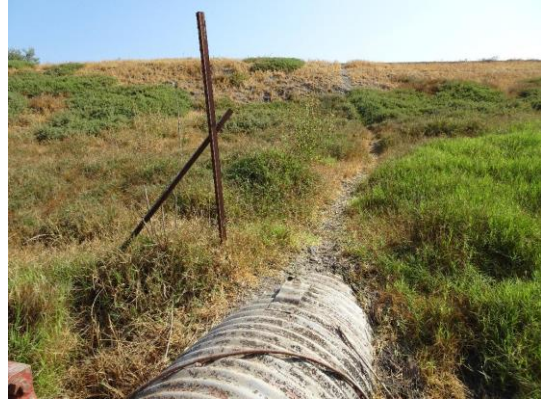
Photo 3 of 3 : UCIP_SP_2022_70648_90629.jpg

WS view: Pipe and slope on WS toe

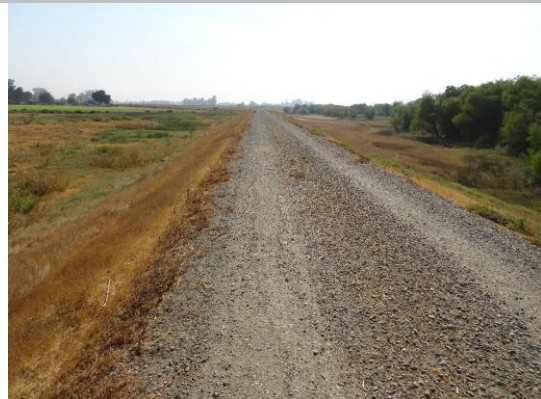
Photo 1 of 3 : UCIP_SP_2022_70649_90632.jpg

FS_ID:70649
 DS_ID:19572
 EP_NO: N/A
 Repair Type: Non-Urgent
 Crossing Status: Found
 UCIP Comments: 10/06/2020 Record has been updated from No Action Needed to Non-Urgent. No permit was found authorizing this encroachment. CVFPB will need to review crossing to determine owner. DWR DMP has not found internal issues, LOF between 1 and 2. Recommend inspection in 5 years. (B. Singh - GEI, O. Magana - DWR UCIP)
 FIELD_STRUCT_DESC: 24-inch corrugated metal (CM) gravity drainage pipe through the levee, 8.0 feet below the crown. Flap gate on the waterside (WS) end. Brass cap No. 100 bench mark (BM) on the headwall on the landside (LS). [Additional Reference(s): DWR Levee Log, 2002, (HLM 2.53). USACE San Joaquin O&M Manual, Unit No. 601, Part No. 1, (SJR601.1), 1967, Revised 25 May 2011, (HLM 2.52)].
 FS Date: 10/6/2020

Overview of levee crown, looking US

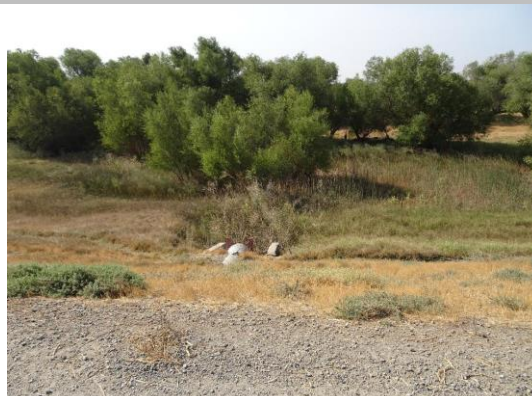
Photo 2 of 3 : UCIP_SP_2022_70649_90633.jpg

WS view: Pipe, headwall, and flapgate visible on WS toe

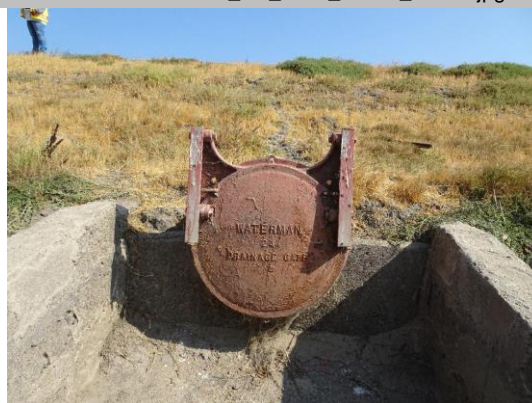
Photo 3 of 3 : UCIP_SP_2022_70649_90635.jpg

WS view: Pipe, flapgate, and headwall on WS toe

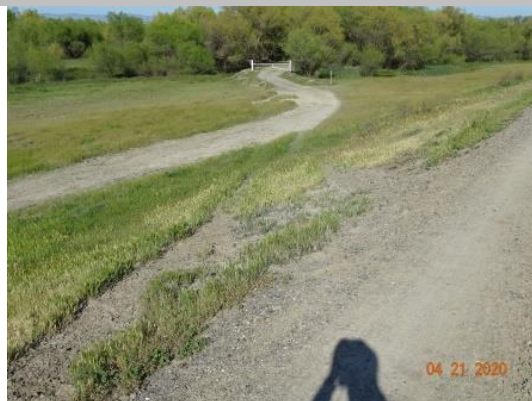
Photo 1 of 1 : SP_2022_NA0010_118_113_20220308_00015.jpg

LM Start	2.58	Rating **	A/W	Issue No.	113
LM End	2.58	Issue Type +	Ma	Location *	WS
Category	Earthen Levee			GPS Latitude/Longitude	
				Start	End
Item	Erosion / Vehicle Traffic			37.327936 °	37.327936 °
				-120.933013 °	-120.933013 °
DWR ID	DWR_NA0010_01_f_2018_113				
Comment Code					
E6 : Repair the levee slope damaged by vehicle traffic and prevent access where possible.					
Inspector Comment					
There is damage caused by vehicle traffic over the levee.

Slope damage by vehicle traffic. (Spring 2020)

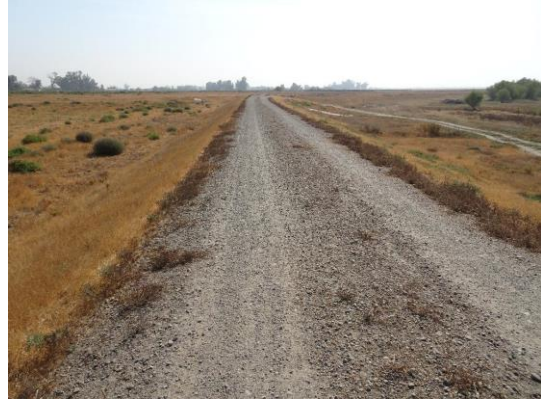
Photo 1 of 3 : UCIP_SP_2022_70650_90637.jpg

Comment Code					
Inspector Comment					
FS_ID:70650 DS_ID:19573 EP_NO: N/A Repair Type: Non-Urgent Crossing Status: Found UCIP Comments: 10/06/2020 Record remains Non-Urgent. No permit was found authorizing this encroachment. CVFPB will need to review crossing to determine owner. DWR DMP has not found internal issues, LOF between 1 and 2. Recommend inspection in 5 years. (B. Singh - GEI, O. Magana - DWR UCIP)04/08/2014 Sedimentation in pipe at landward toe. (W. Wylie - DWR UCIP) FIELD_STRUCT_DESC: 24-inch corrugated metal (CM) gravity drainage pipe through the levee, 7.3 feet below the crown. Flap gate on the waterside (WS) end. Brass cap No. 100 bench mark (BM) on the headwall on the landside (LS). [Additional Reference(s): DWR Levee Log, 2002, (HLM 2.71). USACE San Joaquin O&M Manual, Unit No. 601, Part No. 1, (SJR601.1), 1967, Revised 25 May 2011, (HLM 2.70)]. FS Date: 10/6/2020

Overview of levee crown, looking US

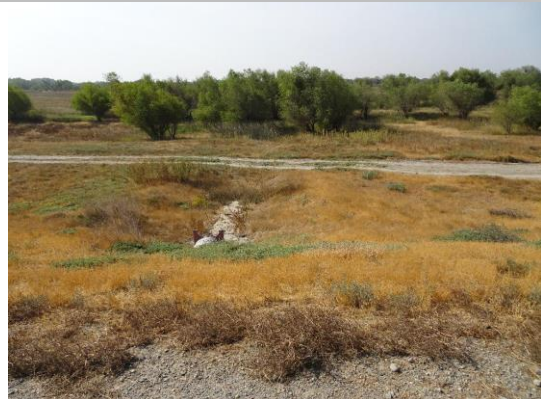
Photo 2 of 3 : UCIP_SP_2022_70650_90638.jpg

WS view: Pipe and flapgate visible on WS toe

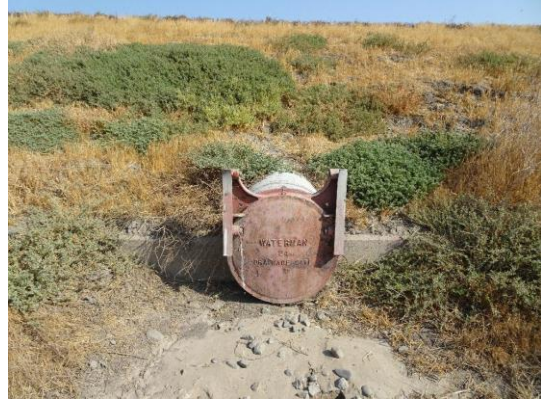
Photo 3 of 3 : UCIP_SP_2022_70650_90640.jpg

WS view: Pipe, flapgate, and headwall at WS toe

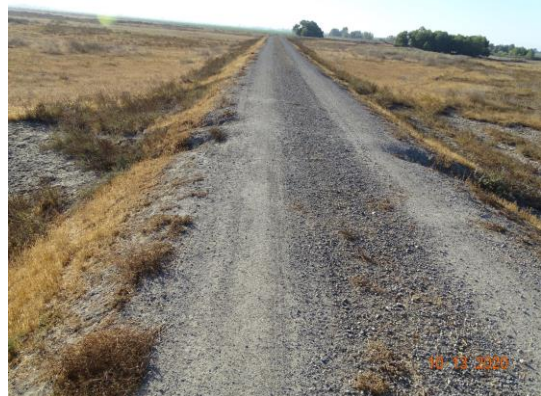
Photo 1 of 1 : SP_2022_NA0010_118_114_20220308_00016.jpg

LM Start	2.99	Rating **	U	Issue No.	114
LM End	2.99	Issue Type +	Ma	Location *	LS
Category	Earthen Levee			GPS Latitude/Longitude	
				Start	End
Item	Erosion / Livestock			37.323328 °	37.323328 °
				-120.929521 °	-120.929521 °
DWR ID	DWR_NA0010_01_f_2018_114				
Comment Code					
E4 : Repair the levee slope damaged by livestock and prevent large animal access.					
Inspector Comment					
Slope damage caused by livestock on both landside and waterside slope has eroded into the levee crown.

View of damage to both slope from livestock activity. (Fall 2020)

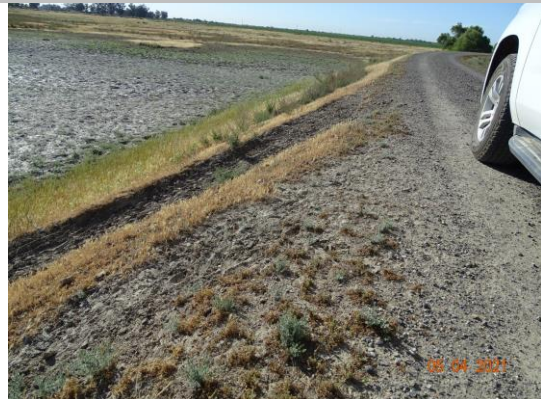
Photo 1 of 1 : SP_2022_NA0010_118_104_20220308_00009.jpg

LM Start	3.06	Rating **	M	Issue No.	104
LM End	3.06	Issue Type +	Ma	Location *	LS
Category	Earthen Levee			GPS Latitude/Longitude	
				Start	End
Item	Erosion / Livestock			37.322499 °	37.322499 °
				-120.928986 °	-120.928986 °
DWR ID	DWR_NA0010_01_f_2017_104				
Comment Code					
E4 : Repair the levee slope damaged by livestock and prevent large animal access.					
Inspector Comment					
Slope damage caused by animal foot traffic.

Slope damage on the landside slope from livestock traffic. (Spring 2021)

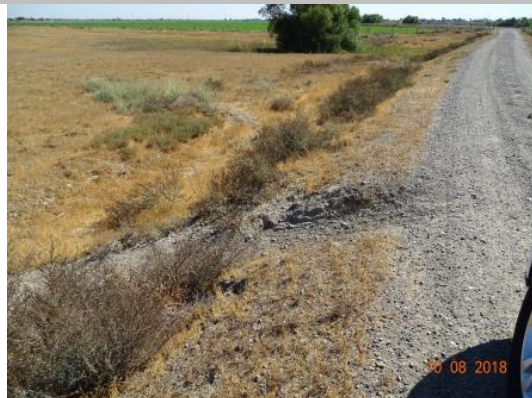
Photo 1 of 1 : SP_2022_NA0010_118_115_20220308_00017.jpg

LM Start	3.10	Rating **	M	Issue No.	115	
LM End	3.10	Issue Type +	Ma	Location *	LS	
Category	Earthen Levee			GPS Latitude/Longitude		
				Start		End
Item	Erosion / Livestock			37.321903 °		37.321903 °
				-120.928748 °		-120.928748 °
DWR ID	DWR_NA0010_01_f_2018_115					
Comment Code						
E4 : Repair the levee slope damaged by livestock and prevent large animal access.						
Inspector Comment						
Damage caused by livestock traffic.

View of erosion path looking downstream. (Fall 2018)

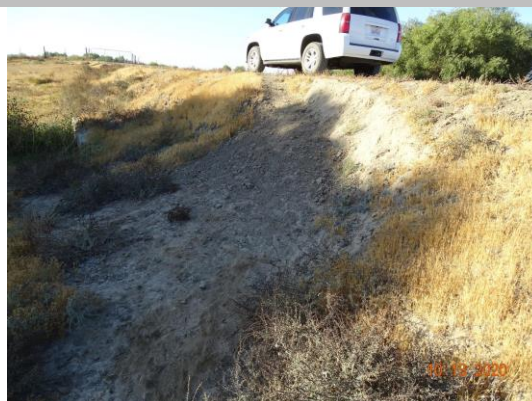
Photo 1 of 1 : SP_2022_NA0010_118_108_20220308_00012.jpg

LM Start	3.13	Rating **	M	Issue No.	108
LM End	3.13	Issue Type +	Ma	Location *	LS
Category	Earthen Levee			GPS Latitude/Longitude	
				Start	End
Item	Erosion / Livestock			37.321488 °	37.321488 °
				-120.928758 °	-120.928758 °
DWR ID	DWR_NA0010_01_s_2017_108				
Comment Code					
E4 : Repair the levee slope damaged by livestock and prevent large animal access.					
Inspector Comment					
Slope damage caused by animal traffic on landside toe.

View of landside slope damage by animal traffic. (Fall 2020)

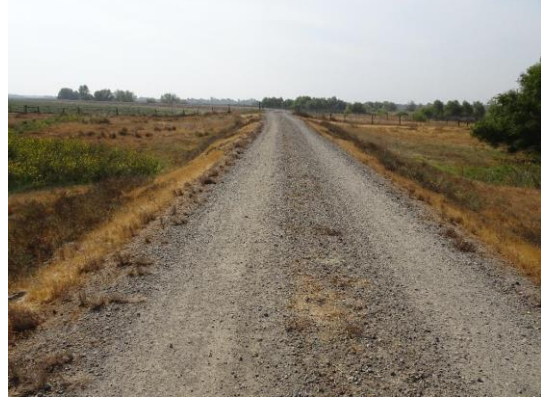
Photo 1 of 3 : UCIP_SP_2022_70651_90644.jpg

Comment Code					
Inspector Comment					
FS_ID:70651 DS_ID:19574 EP_NO: N/A Repair Type: Non-Urgent Crossing Status: Found UCIP Comments: 10/06/2020 Record remains Non-Urgent. No permit was found authorizing this encroachment. CVFPB will need to review crossing to determine owner. DWR DMP internal inspection is pending and scheduled for 2021. (B. Singh - GEI, O. Magana - DWR UCIP)04/08/2014 Some minor erosion around headwall on LS toe. (W. Wylie - DWR UCIP) FIELD_STRUCT_DESC: 36-inch corrugated metal (CM) gravity drainage pipe through the levee, 8.0 feet below the crown. Flap gate on the waterside (WS) end. Brass cap No. 100 bench mark (BM) on the headwall on the landside (LS). [Additional Reference(s): DWR Levee Log, 2002, (HLM 3.17). USACE San Joaquin O&M Manual, Unit No. 601, Part No. 1, (SJR601.1), 1967, Revised 25 May 2011, (HLM 3.16)]. FS Date: 10/6/2020

Overview of levee crown, looking US

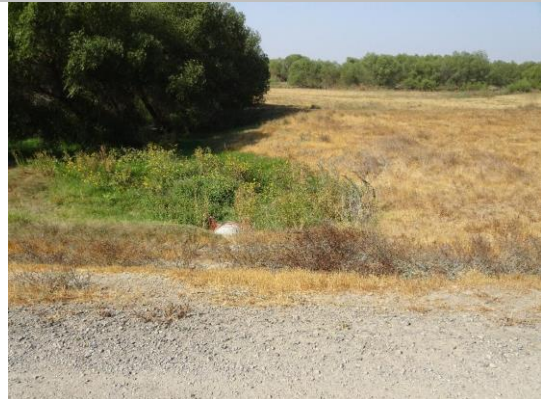
Photo 2 of 3 : UCIP_SP_2022_70651_90645.jpg

WS view: Pipe and flapgate visible at WS toe

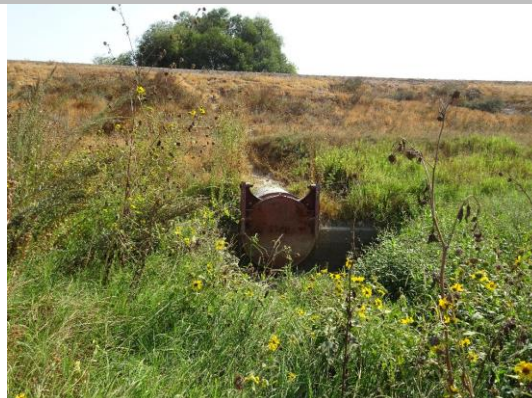
Photo 3 of 3 : UCIP_SP_2022_70651_90646.jpg

WS view: Pipe, flapgate, and headwall at WS toe

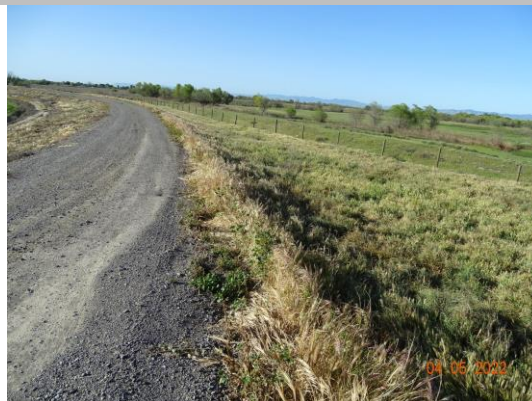
Photo 1 of 1 : SP_2022_NA0010_118_123_20220412_00299.jpg

LM Start	3.16	Rating **	M	Issue No.	123
LM End	3.35	Issue Type +	Ma	Location *	WS
Category	Earthen Levee			GPS Latitude/Longitude	
				Start	End
Item	Vegetation			37.321052 °	37.318644 °
				-120.928812 °	-120.927340 °
DWR ID	DWR_NA0010_01_s_2022_123				
Comment Code					
V1 : Control annual grass and weeds on the levee slopes and easements.					
Inspector Comment

View of the waterside slope looking upstream. (Spring 2022)

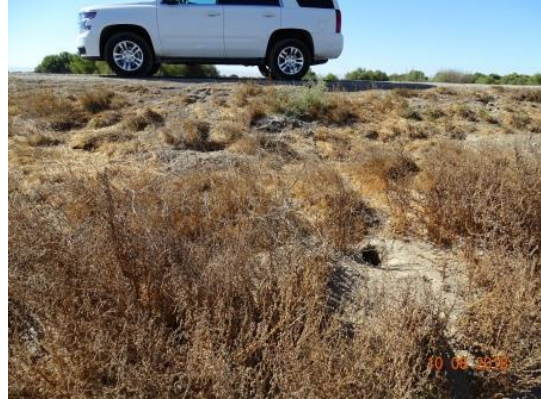
Photo 1 of 1 : SP_2022_NA0010_118_116_20220308_00018.jpg

LM Start	3.18	Rating **	M	Issue No.	116
LM End	3.18	Issue Type +	Ma	Location *	LS
Category	Earthen Levee			GPS Latitude/Longitude	
				Start	End
Item	Animal Control			37.320725 °	37.320725 °
				-120.928837 °	-120.928837 °
DWR ID	DWR_NA0010_01_f_2018_116				
Comment Code					
A3 : No rodents visible, but rodent burrows visible; need to backfill and compact or grout burrows.					
Inspector Comment					
Several rodent holes noted in this section.

View of landside slope with rodent holes. (Fall 2018)

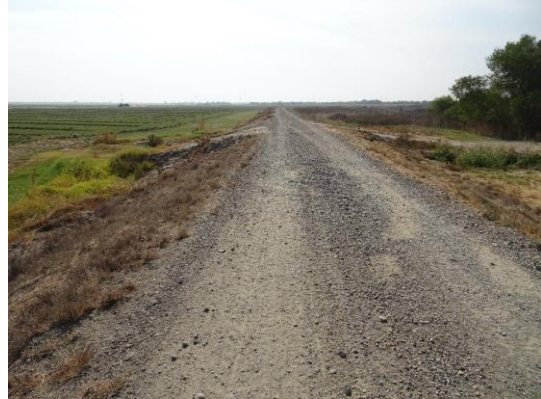
Photo 1 of 3 : UCIP_SP_2022_70652_90588.jpg

Comment Code					
Inspector Comment					
FS_ID:70652 DS_ID:19575 EP_NO: N/A Repair Type: Urgent Crossing Status: Found UCIP Comments: 10/06/2020 Record remains Urgent. Sinkhole present directly above the LS headwall and along pipe alignment. Pipe collapse visible from from the LS toe. Erosion present on the WS just behind the flap gate. No permit was found authorizing this encroachment. CVFPB will need to review crossing to determine owner. DWR DMP internal inspection is pending and scheduled in 2021. (B. Singh - GEI, O. Magana - DWR UCIP)11/01/2018 Pipe continues to rust through, causing the pipe to collapse on the LS. Sediment buildup visible from the LS inlet. Loss of soil just above the LS concrete headwall and along the LS slope. Crossing remains Urgent due to the levee slope issues and pipe failure through the levee. (O. Magana - DWR UCIP)07/19/2016 Same as previous inspection. Erosion present on LS slope. (O. Magana - DWR UCIP)04/08/2014 Pipe rusted through at Springline on LS toe. Flapgate blocked by sediment on WS toe. Heavy sediment on both ends of pipe. Need to contact owner to address issues. (W. Wylie - DWR UCIP) FIELD_STRUCT_DESC: 36-inch corrugated metal (CM) gravity drainage pipe through the levee, 9.7 feet below the crown. Flap gate on the waterside (WS) end. Brass cap No. 100 bench mark (BM) on the headwall on the landside (LS). [Additional Reference(s): DWR Levee Log, 2002, (HLM 3.50). USACE San Joaquin O&M Manual, Unit No. 601, Part No. 1, (SJR601.1), 1967, Revised 25 May 2011, (HLM 3.50)]. FS Date: 10/6/2020

Overview of levee crown, looking US

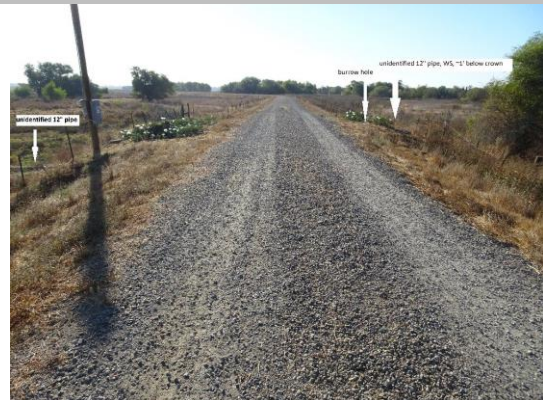
Photo 1 of 3 : UCIP_SP_2022_70655_90661.jpg

FS_ID:70655
DS_ID:19607
EP_NO: N/A
Repair Type: Non-Urgent
Crossing Status: Found
UCIP Comments: 10/20/2020 Record remains Non-Urgent. Barbed wire prevented access to the pipe located on the LS toe. Unpermitted modifications were made to the structure. There appears to be multiple crossings at this location, two 12-inch pipes and 48-inch refurbished pipe. Recommend adding new DSID for the second 12-inch pipe found during field inspection. Portion of concrete headwall visible on the WS toe that corresponds to 48-inch pipe. Recommend contacting owner to determine status of structure and obtain as-builts. No permit was found authorizing these encroachments. CVFPB will need to review crossing to determine owner(s). (B. Singh - GEI, O. Magana - DWR UCIP)04/08/2014 Pipe appears sleeved with a 12-inch steel pipe with a slide gate at the LS toe. No identified authorization for changes to this crossing. Need to contact owner to obtain additional information about the modifications to crossing. (W. Wylie - DWR UCIP)

Overview of levee crown showing location of burrow hole and alignment of unauthorized 12" pipe

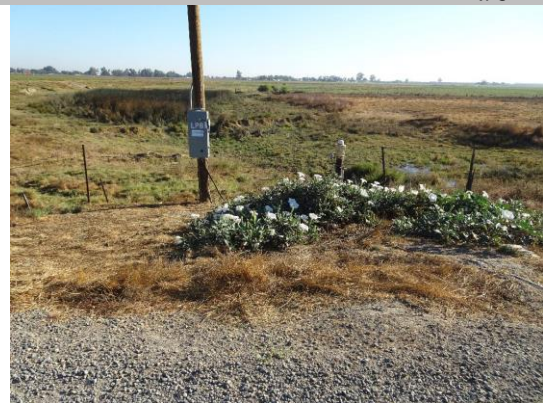
Photo 2 of 3 : UCIP_SP_2022_70655_90659.jpg

LS view: View toward LS toe from levee crown

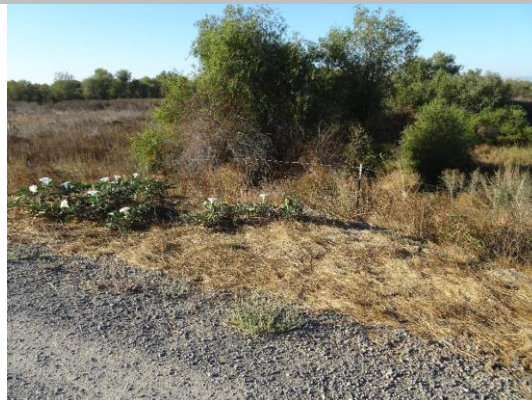
Photo 3 of 3 : UCIP_SP_2022_70655_90660.jpg

WS view: View toward WS toe from levee crown

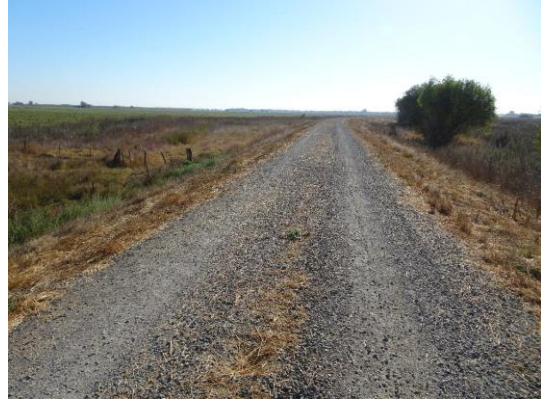
Photo 1 of 3 : UCIP_SP_2022_70657_90668.jpg

Comment Code					
Inspector Comment					
FS_ID:70657 DS_ID:19608 EP_NO: N/A Repair Type: Non-Urgent Crossing Status: Found UCIP Comments: 10/20/2020 Record remains Non-Urgent. Fence and dense vegetation prevented full inspection along the WS and LS slopes. Burrowing observed on LS and WS slopes. No permit was found authorizing this encroachment. CVFPB will need to review crossing to determine owner. DWR DMP internal inspection is pending and scheduled for 2021. (B. Singh - GEI, O. Magana - DWR UCIP)04/08/2014 Dense vegetation and fence limits the inspector's visibility to identify signs of pipe failure (leaks) along the landward side. Recommend obtaining access to landward toe and removing vegetation along pipe alignment to conduct proper inspection of structure and appurtenances. (W. Wylie - DWR UCIP) FIELD_STRUCT_DESC: 24-inch corrugated metal (CM) gravity drainage pipe through the levee, 11.9 feet below the crown. Flap gate on the waterside (WS) end. Brass cap No. 90 bench mark (BM) on the headwall on the landside (LS). [Additional Reference(s): DWR Levee Log, 2002, (HLM 4.27). USACE San Joaquin O&M Manual, Unit No. 601, Part No. 1, (SJR601.1), 1967, Revised 25 May 2011, (HLM 4.27)]. FS Date: 10/20/2020

Overview of levee crown, looking US

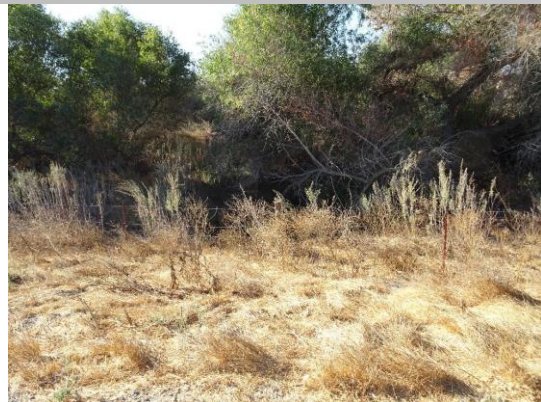
Photo 2 of 3 : UCIP_SP_2022_70657_90670.jpg

LS view: View toward LS toe from levee crown

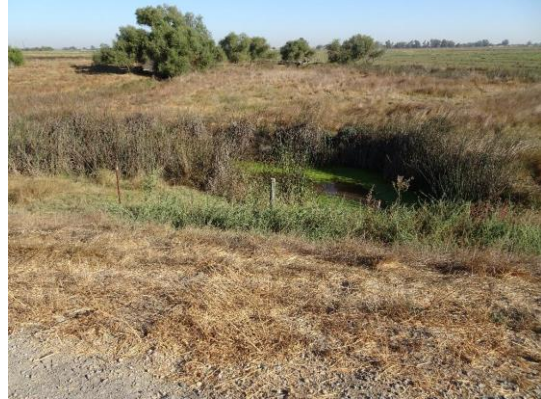
Photo 3 of 3 : UCIP_SP_2022_70657_90669.jpg

WS view: View toward WS toe from levee crown
