**Flood Control Project Maintenance
Levee Inspections**

Maintenance Issue Types Only, Levee Inspection Report By Mile - Spring 2022

Lower San Joaquin Levee District

Waterway	Bank	Unit Miles	Inspection Start/End	Inspector
Unit No. 01 San Joaquin River	Right	22.52	04/05/2022 04/05/2022	Corey Fujitani

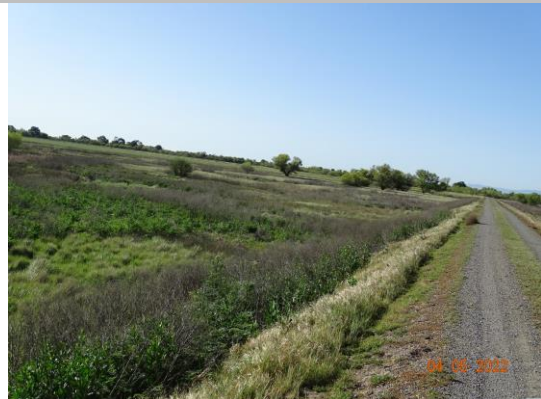
Photo 1 of 1 : SP_2022_NA0010_118_124_20220412_00300.jpg

LM Start	4.31	Rating **	M	Issue No.	124
LM End	4.78	Issue Type +	Ma	Location *	LS
Category	Earthen Levee			GPS Latitude/Longitude	
				Start	End
Item	Vegetation			37.307525 °	37.301192 °
				-120.921965 °	-120.920599 °
DWR ID	DWR_NA0010_01_s_2022_124				
Comment Code					
V1 : Control annual grass and weeds on the levee slopes and easements.					
Inspector Comment

View of vegetation growing on the landside slope. (Spring 2022)

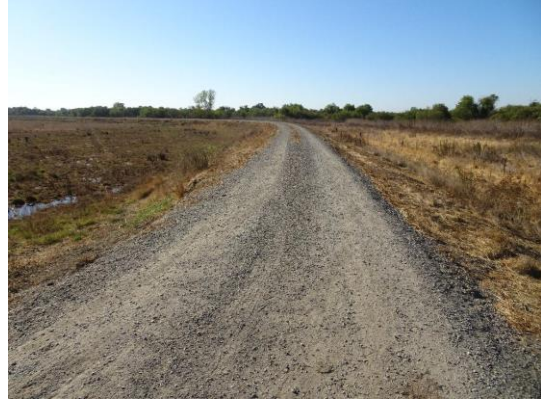
Photo 1 of 3 : UCIP_SP_2022_70658_90676.jpg

Comment Code					
Inspector Comment					
FS_ID:70658 DS_ID:19609 EP_NO: N/A Repair Type: Urgent Crossing Status: Found UCIP Comments: 10/20/2020 Record has been updated from Non-Urgent to Urgent. DWR DMP has found integrity issues, LOF, between 5 and 6. Crossing will be monitored until funding becomes available to address. Evidence of the landslide visible on the LS slope from the levee crown. No permit was found authorizing this encroachment. CVFPB will need to review crossing to determine owner. (B. Singh - GEI, O. Magana - DWR UCIP)04/08/2014 Dense vegetation limits the inspector's visibility to identify signs of pipe failure (leaks) along the waterward side. Recommend removing vegetation along pipe alignment to conduct proper inspection of structure and appurtenances. (W. Wylie - DWR UCIP) FIELD_STRUCT_DESC: 24-inch corrugated metal (CM) gravity drainage pipe through the levee, 10.0 feet below the crown. Flap gate on the waterside (WS) end. Brass cap No. 90 bench mark (BM) on the headwall on the landside (LS). [Additional Reference(s): DWR Levee Log, 2002, (HLM 4.73). USACE San Joaquin O&M Manual, Unit No. 601, Part No. 1, (SJR601.1), 1967, Revised 25 May 2011, (HLM 4.72)]. FS Date: 10/20/2020

Overview of levee crown, looking US

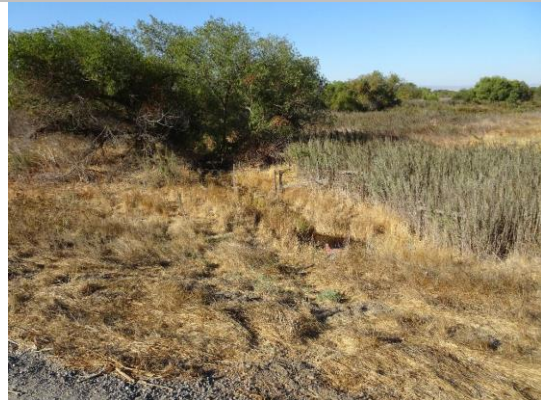
Photo 2 of 3 : UCIP_SP_2022_70658_90678.jpg

WS view: Pipe and flapgate visible at WS toe

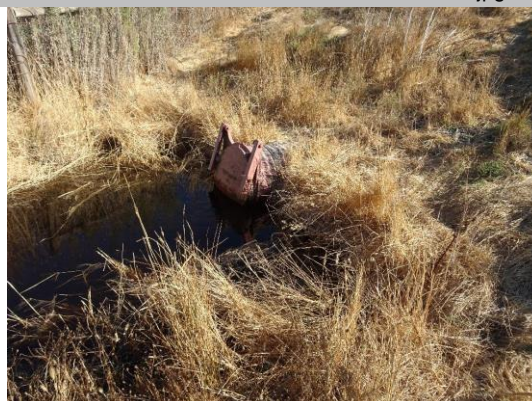
Photo 3 of 3 : UCIP_SP_2022_70658_90679.jpg

WS view: Pipe and flapgate at WS toe

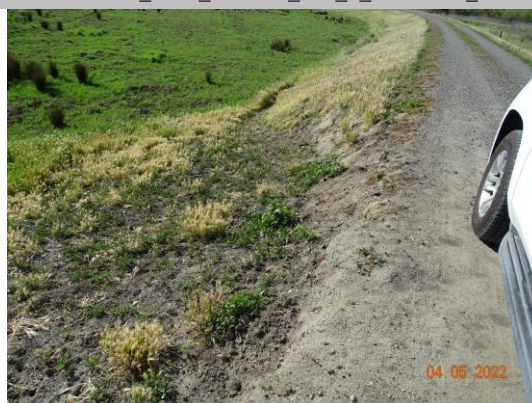
Photo 1 of 1 : SP_2022_NA0010_118_9_20220412_00301.jpg

LM Start	4.69	Rating **	M	Issue No.	9
LM End	4.69	Issue Type +	Ma	Location *	LS
Category	Earthen Levee			GPS Latitude/Longitude	
				Start	End
Item	Erosion / Livestock			37.302398 °	37.302398 °
				-120.920920 °	-120.920920 °
DWR ID	DWR_NA0010_01_s_2013_9				
Comment Code					
E4 : Repair the levee slope damaged by livestock and prevent large animal access.					
Inspector Comment					
Material used to repair the livestock damage in 2021 has eroded away.

View of damage to the landside slope from livestock. (Spring 2022)

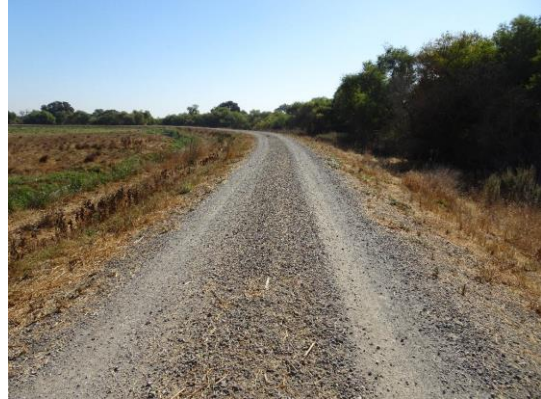
Photo 1 of 3 : UCIP_SP_2022_70659_90682.jpg

Comment Code						
Inspector Comment						
FS_ID:70659 DS_ID:19610 EP_NO: N/A Repair Type: Non-Urgent Crossing Status: Found UCIP Comments: 10/20/2020 Record remains Non-Urgent. Unable to locate inlet on the LS toe. Ditch runs along the LS toe. Ditch was running full and no signs of pipe inlet were visible. This pipe appears to be non-functional--only WS pipe outlet found. No permit was found authorizing this encroachment. CVFPB will need to review crossing to determine owner. DWR DMP internal inspection is pending and scheduled for 2021. (B. Singh - GEI, O. Magana - DWR UCIP)04/08/2014 Non-functional -- sediment buildup against flapgate and inlet buried at landward side. (W. Wylie - DWR UCIP) FIELD_STRUCT_DESC: 24-inch corrugated metal (CM) gravity drainage pipe through the levee, 8.0 feet below the crown. Flap gate on the waterside (WS) end. Brass cap No. 90 bench mark (BM) on the headwall on the landside (LS). Drainage ditch along the LS toe. [Additional Reference(s): DWR Levee Log, 2002, (HLM 5.06). USACE San Joaquin O&M Manual, Unit No. 601, Part No. 1, (SJR601.1), 1967, Revised 25 May 2011, (HLM 5.05)]. FS Date: 10/20/2020

Overview of levee crown, looking US

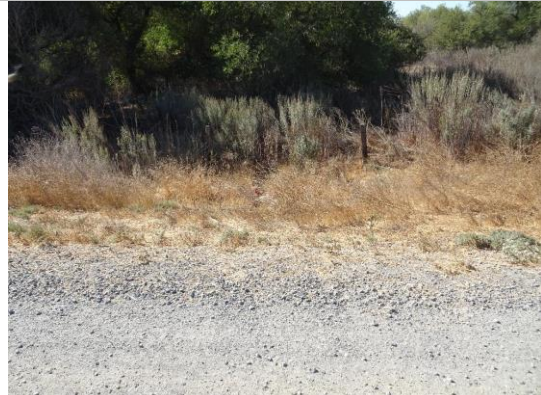
Photo 2 of 3 : UCIP_SP_2022_70659_90684.jpg

WS view: Pipe and flapgate visible on WS toe

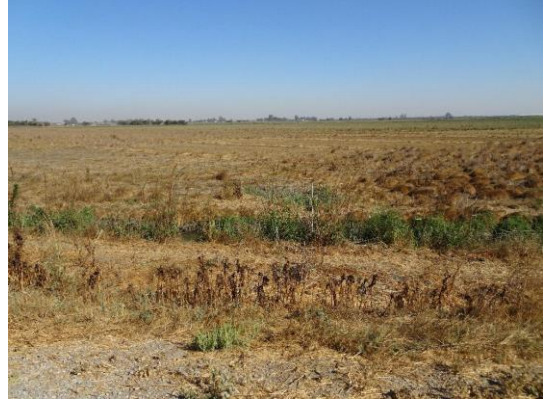
Photo 3 of 3 : UCIP_SP_2022_70659_90683.jpg

LS view: Pipe and headwall not visible at LS toe from levee crown

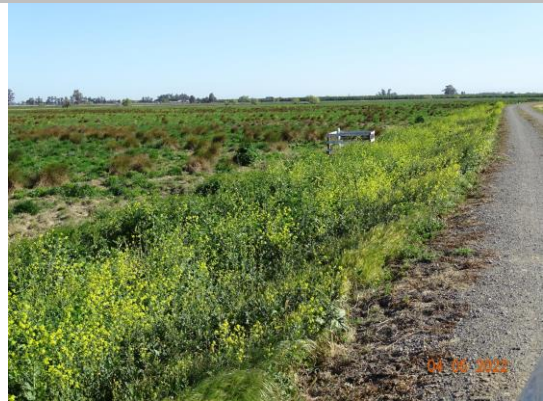
Photo 1 of 1 : SP_2022_NA0010_118_125_20220412_00302.jpg

LM Start	5.43	Rating **	M	Issue No.	125
LM End	6.53	Issue Type +	Ma	Location *	LS
Category	Earthen Levee			GPS Latitude/Longitude	
				Start	End
Item	Vegetation			37.301512 °	37.304059 °
				-120.911230 °	-120.893346 °
DWR ID	DWR_NA0010_01_s_2022_125				
Comment Code					
V1 : Control annual grass and weeds on the levee slopes and easements.					
Inspector Comment

Looking upstream along the landside slope. (Spring 2022)

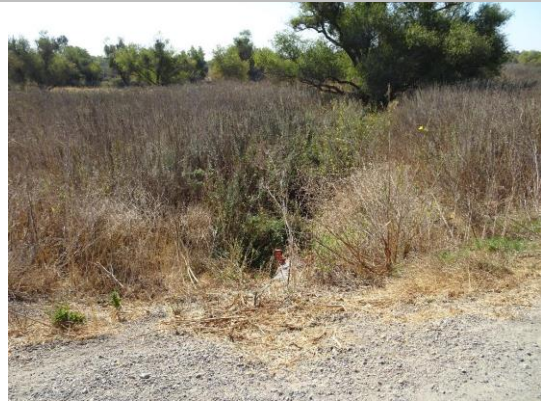
Photo 2 of 3 : UCIP_SP_2022_70660_90691.jpg

Comment Code					
Inspector Comment					
FS_ID:70660 DS_ID:19611 EP_NO: N/A Repair Type: Non-Urgent Crossing Status: Found UCIP Comments: 10/20/2020 Record remains Non-Urgent. Depression observed across levee crown, less than 6 inches in depth. Pipe inlet located at the LS toe is completely blocked by soil. This crossing is non-functional. Recommend evaluating the purpose of this drainage structure. No permit was found authorizing this encroachment. CVFPB will need to review crossing to determine owner. DWR DMP internal inspection is pending and scheduled for 2021. Recommend reviewing DMP's internal inspection when completed to investigate reason for depression across the levee crown. (B. Singh - GEI, O. Magana - DWR UCIP)04/08/2014 Dense vegetation limits the inspector's visibility to identify signs of pipe failure (leaks) along waterward and landward slopes. Recommend removing vegetation along pipe alignment to conduct proper inspection of structure and appurtenances. Landward side filled in with soil. Need to contact owner. If crossing is no longer used need to coordinate with CVFPB for proper abandonment. (W. Wylie - DWR UCIP) FIELD_STRUCT_DESC: 24-inch corrugated metal (CM) gravity drainage pipe through the levee, 8.6 feet below the crown. Flap gate on the waterside (WS) end. Brass cap No. 90 bench mark (BM) on the headwall on the landside (LS). [Additional Reference(s): DWR Levee Log, 2002, (HLM 5.96). USACE San Joaquin O&M Manual, Unit No. 601, Part No. 1, (SJR601.1), 1967, Revised 25 May 2011, (HLM 5.95)]. FS Date: 10/20/2020

WS view: Pipe and flapgate visible at WS toe

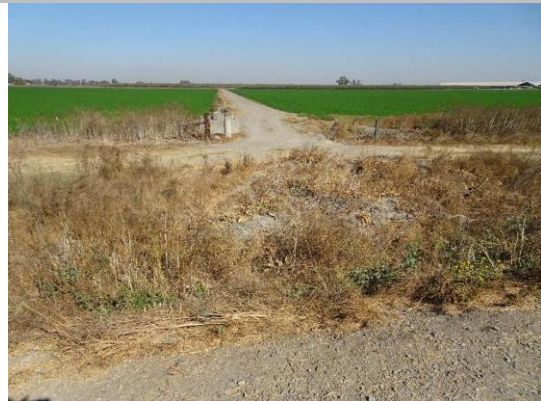
Photo 3 of 3 : UCIP_SP_2022_70660_90690.jpg

LS view: View of LS toe from levee crown. Pipe and headwall not visible

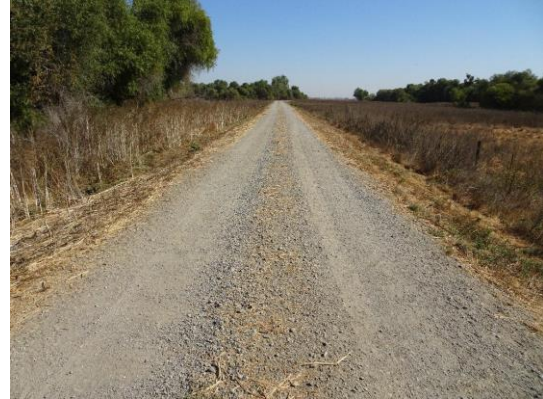
Photo 1 of 3 : UCIP_SP_2022_70661_90696.jpg

Comment Code					
Inspector Comment					
FS_ID:70661 DS_ID:19612 EP_NO: N/A Repair Type: Non-Urgent Crossing Status: Found UCIP Comments: 10/20/2020 Record remains Non-Urgent. Scour is still present on both sides of the concrete LS headwall. Dense vegetation prevented updates on the scour progression along the LS slope. Recommend re-inspecting pipe when vegetation is removed. Unable to access to WS outlet due to wired fence. No permit was found authorizing this encroachment. CVFPB will need to review crossing to determine owner. DWR DMP internal inspection is pending and scheduled for 2021. (B. Singh - GEI, O. Magana - DWR UCIP)04/08/2014 Dense vegetation limits the inspector's visibility to identify signs of pipe failure (leaks) along waterward and landward slopes. Recommend removing vegetation along pipe alignment to conduct proper inspection of structure and appurtenances. Pipe completely blocked by soil on LS toe due to animal activity. Slide gate blocked open. (W. Wylie - DWR UCIP) FIELD_STRUCT_DESC: 48-inch corrugated metal (CM) gravity drainage pipe through the levee at an angle, 13.1 feet below the crown. Walkway to slide gate at the concrete headwall on the landside (LS) toe. Flap gate at the concrete headwall on the waterside (WS) toe. Brass cap No. 90 bench mark (BM) on the headwall on the LS. [Additional Reference(s): DWR Levee Log, 2002, (HLM 6.13). USACE San Joaquin O&M Manual, Unit No. 601, Part No. 1, (SJR601.1), 1967, Revised 25 May 2011, (HLM 6.13)]. FS Date: 10/20/2020

Overview of levee crown, looking US

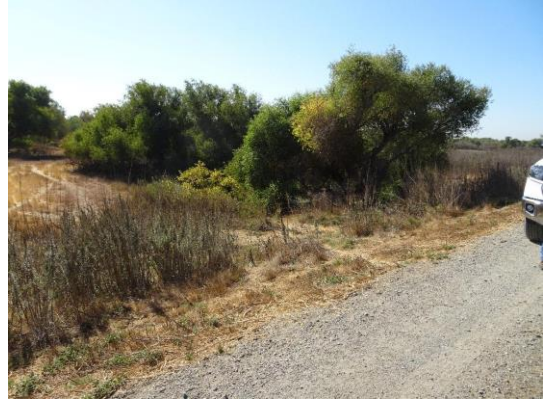
Photo 2 of 3 : UCIP_SP_2022_70661_90698.jpg

WS view: View of WS toe from levee crown. Headwall, pipe, and flapgate not visible from levee crown.

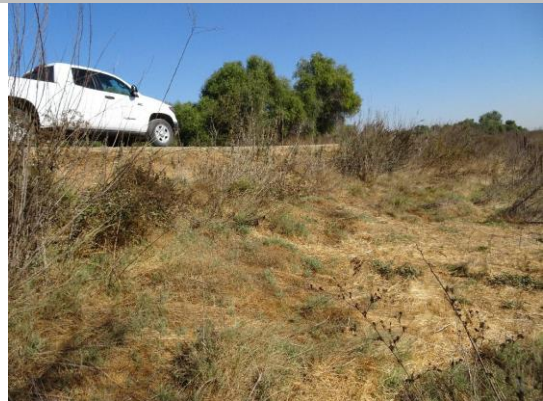
Photo 3 of 3 : UCIP_SP_2022_70661_90695.jpg

WS view: Levee slope from WS toe

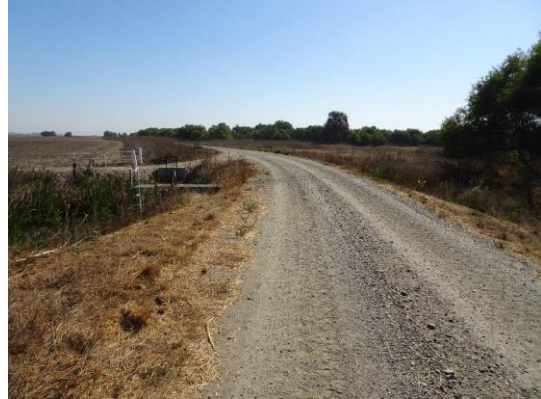
Photo 1 of 3 : UCIP_SP_2022_70662_90702.jpg

Comment Code					
Inspector Comment					
FS_ID:70662 DS_ID:19613 EP_NO: N/A Repair Type: Non-Urgent Crossing Status: Found UCIP Comments: 10/20/2020 Record remains Non-Urgent. Dense vegetation on WS toe, recommend removal for proper inspection. Minor surface erosion visible on the LS toe near the standpipe. No permit was found authorizing this encroachment. CVFPB will need to review crossing to determine owner. DWR DMP internal inspection is pending and scheduled for 2021. (B. Singh - GEI, O. Magana - DWR UCIP)04/08/2014 Dense vegetation limits the inspector's visibility to identify signs of pipe failure (leaks) along the slope. Recommend removing vegetation along pipe alignment to conduct proper inspection of structure and appurtenances. (W. Wylie - DWR UCIP) FIELD_STRUCT_DESC: 24-inch corrugated metal (CM) gravity drainage pipe through the levee, 9.5 feet below the crown. Flap gate on the waterside (WS) end. Slide gate on the landside (LS) end next to a 48-inch concrete riser unit with walkway over the top. Brass cap No. 90 bench mark (BM) on the headwall on the LS. [Additional Reference(s): DWR Levee Log, 2002, (HLM 6.44). USACE San Joaquin O&M Manual, Unit No. 601, Part No. 1, (SJR601.1), 1967, Revised 25 May 2011, (HLM 6.40)]. FS Date: 10/20/2020

Overview of levee crown, looking upstream

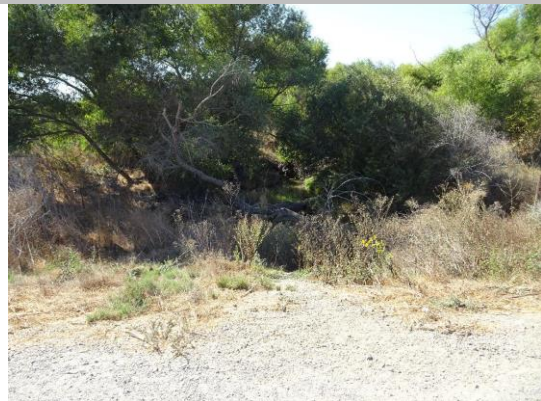
Photo 2 of 3 : UCIP_SP_2022_70662_90705.jpg

WS view: Headwall not visible on WS toe due to dense vegetation

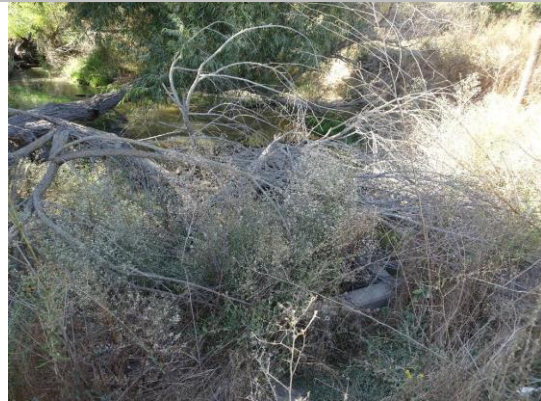
Photo 3 of 3 : UCIP_SP_2022_70662_90706.jpg

WS view: Inspection of WS headwall, pipe, and flapgate inhibited by dense vegetation

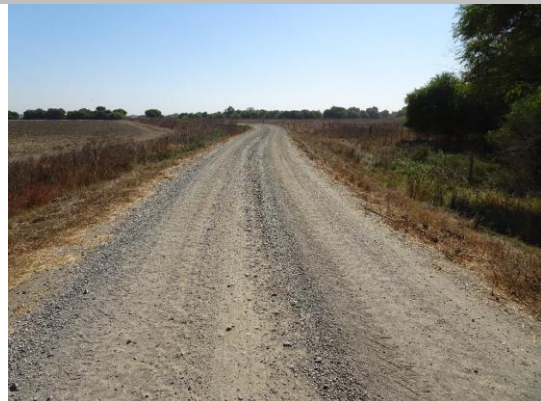
Photo 1 of 3 : UCIP_SP_2022_70663_90712.jpg

FS_ID:70663
DS_ID:19614
EP_NO: N/A
Repair Type: Non-Urgent
Crossing Status: Found
UCIP Comments: 10/20/2020 Record remains Non-Urgent. Dense vegetation inhibits inspection of the pipe on the LS toe, and both slopes. No permit was found authorizing this encroachment. CVFPB will need to review crossing to determine owner. DWR DMP internal inspection is pending and scheduled for 2021. (B. Singh - GEI, O. Magana - DWR UCIP)7/19/2016 Same as previous inspection. Outlet and inlet are under water. (O. Magana - DWR UCIP)4/08/2014 Flapgate blocked by sedimentation at WS toe. Dense vegetation limits the inspector's visibility to identify signs of pipe failure (leaks) along the slope. Recommend removing vegetation along pipe alignment to conduct proper inspection of structure and appurtenances. Also recommend clearing vegetation from both waterward and landward toe. (W. Wylie - DWR UCIP)
FIELD_STRUCT_DESC: 24-inch corrugated metal (CM) gravity drainage pipe through the levee, 9.8 feet below the crown. Wooden fence around a 4-foot by 4-foot drop inlet on the landside (LS) toe. Flap gate on the waterside (WS) end. Brass cap No. 90 bench mark (BM) on the headwall on the LS. [Additional Reference(s): DWR Levee Log, 2002, (HLM 6.65). USACE San Joaquin O&M Manual, Unit No. 601, Part No. 1, (SJR601.1), 1967, Revised 25 May 2011, (HLM 6.64)].

Overview of levee crown, looking US

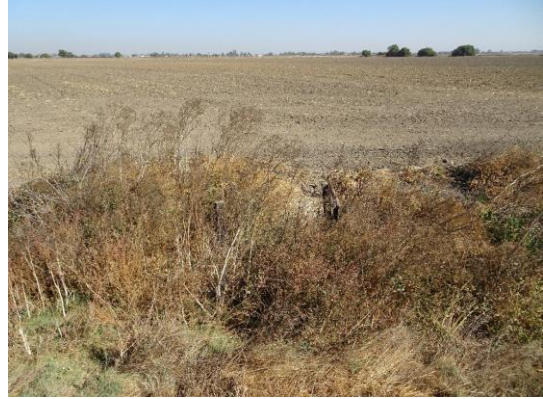
Photo 2 of 3 : UCIP_SP_2022_70663_90713.jpg

LS view: Dense vegetation on LS limiting view of wooden barrier around drop-inlet.

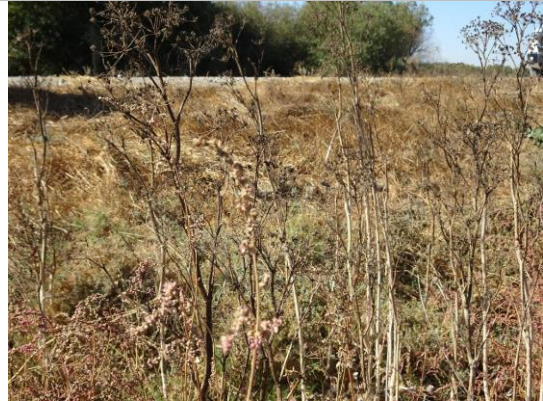
Photo 3 of 3 : UCIP_SP_2022_70663_90707.jpg

LS view: LS slope from LS toe

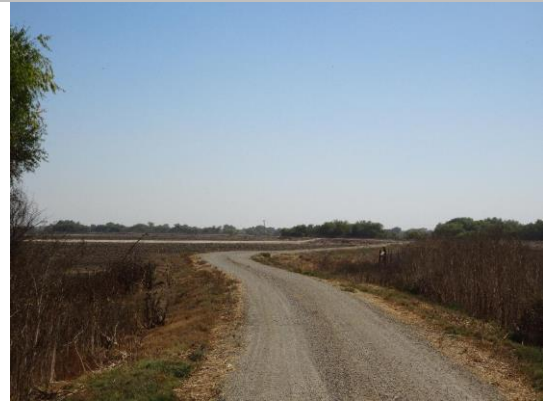
Photo 1 of 3 : UCIP_SP_2022_70664_90726.jpg

FS_ID:70664
DS_ID:19615
EP_NO: N/A
Repair Type: Urgent
Crossing Status: Found
UCIP Comments: 10/20/2020 Record has been updated from Non-Urgent to Urgent. Heavy corrosion present with visible holes found at the WS outlet near flap gate. Surface erosion present on the LS slope just upstream of slide gate. Evidence of surface erosion on the WS slope (vertical slope) was present approximately 15 feet downstream of the pipe. Plastic sheeting has been placed to prevent further erosion by LMA (assumed). Recommend notifying DWR Levee Inspector to monitor progress of surface erosion on the WS. No permit was found authorizing this encroachment. CVFPB will need to review crossing to determine owner. DWR DMP internal inspection is pending and scheduled for 2021. (B. Singh - GEI, O. Magana - DWR UCIP)07/19/2016 Potential LS slope damage--difficult to determine due to dense vegetation. Limited access on WS toe due to wire fence. (O. Magana - DWR UCIP)04/08/2014 Slide gate blocked by debris at LS toe. Flapgate won't close because of debris. Dense vegetation limits the inspector's visibility to identify signs of pipe failure (leaks) along the slope. Recommend removing vegetation along pipe alignment to conduct proper inspection of structure and appurtenances. (W. Wylie - DWR UCIP)

Overview of levee crown, looking US

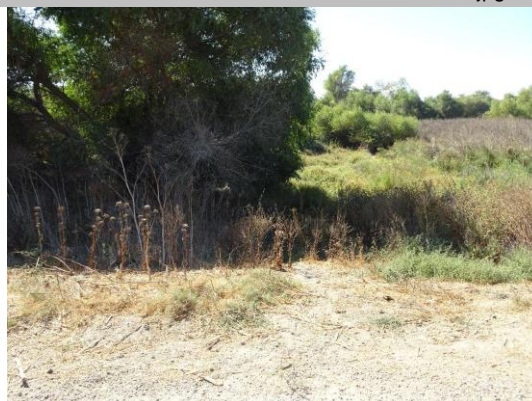
Photo 2 of 3 : UCIP_SP_2022_70664_92389.jpg

WS view: overview of WS.

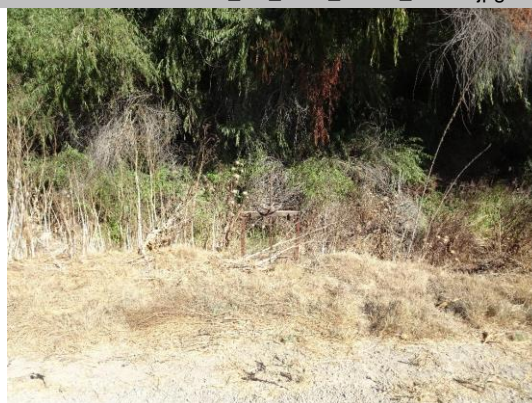
Photo 3 of 3 : UCIP_SP_2022_70664_90727.jpg

LS view: Pipe slidegate visible at LS toe.

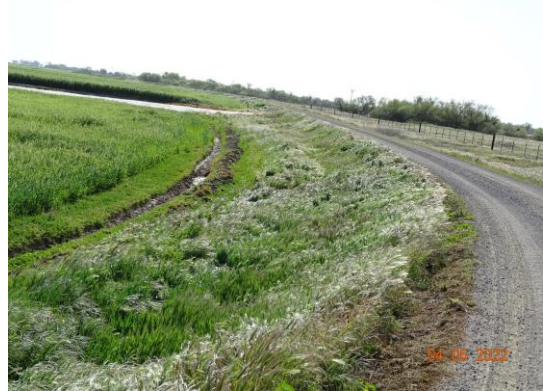
Photo 1 of 1 : SP_2022_NA0010_118_127_20220412_00303.jpg

LM Start	6.91	Rating **	M	Issue No.	127
LM End	8.67	Issue Type +	Ma	Location *	LS
Category	Earthen Levee			GPS Latitude/Longitude	
				Start	End
Item	Vegetation			37.301779 °	37.296873 °
				-120.887140 °	-120.856985 °
DWR ID	DWR_NA0010_01_s_2022_127				
Comment Code					
V1 : Control annual grass and weeds on the levee slopes and easements.					
Inspector Comment

View of vegetation growing on the landside slope. (Spring 2022)

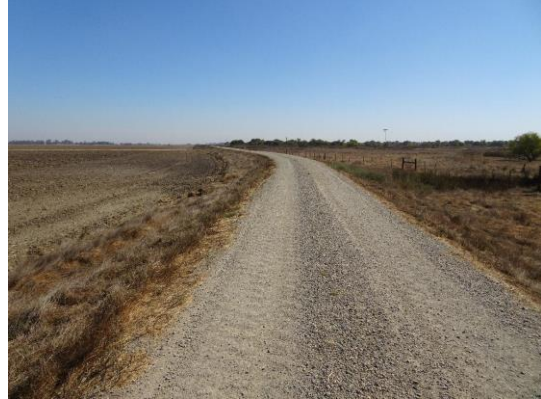
Photo 1 of 3 : UCIP_SP_2022_70665_90715.jpg

Comment Code						
Inspector Comment						
FS_ID:70665 DS_ID:19616 EP_NO: N/A Repair Type: Urgent Crossing Status: Found UCIP Comments: 10/20/2020 Record remains Urgent. DWR DMP has found integrity issues, LOF between 5 and 6. Pipe deeply corroded. Crossing will be monitored until funding becomes available to address. No permit was found authorizing this encroachment. CVFPB will need to review crossing to determine owner. (B. Singh - GEI, O. Magana - DWR UCIP)11/01/2018 Pipe continues to corrode through. Voids (undermining) along pipe invert are visible from the LS. Potential undermining caused by erosion under concrete apron on the WS. Crossing remains Urgent due to the pipe failure. (O. Magana - DWR UCIP)04/08/2014 Pipe failing and corroded through at LS toe. Need to contact owner to determine status of crossing. Also dense vegetation limits the inspector's visibility to identify signs of pipe failure (leaks) along the landward slope. Recommend removing vegetation along pipe alignment to conduct proper inspection of structure. (W. Wylie - DWR UCIP) FIELD_STRUCT_DESC: 24-inch corrugated metal (CM) gravity drainage pipe through the levee, 5.1 feet below the crown. Flap gate on the waterside (WS) end. Brass cap No. 90 bench mark (BM) on the headwall on the landside (LS). [Additional Reference(s): DWR Levee Log, 2002, (HLM 7.22). USACE San Joaquin O&M Manual, Unit No. 601, Part No. 1, (SJR601.1), 1967, Revised 25 May 2011, (HLM 7.21)]. FS Date: 10/20/2020

Overview of levee crown, looking US

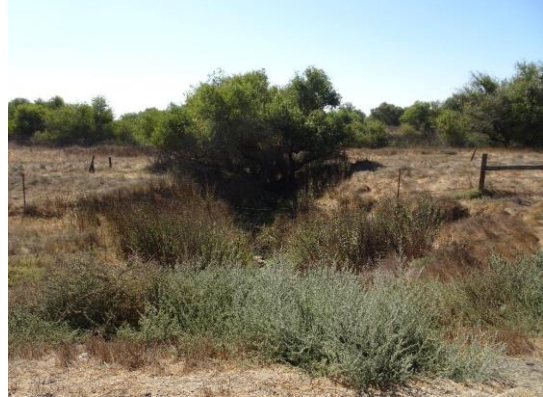
Photo 2 of 3 : UCIP_SP_2022_70665_90717.jpg

WS view: Pipe and flapgate at WS toe not visible from levee crown due to vegetation.

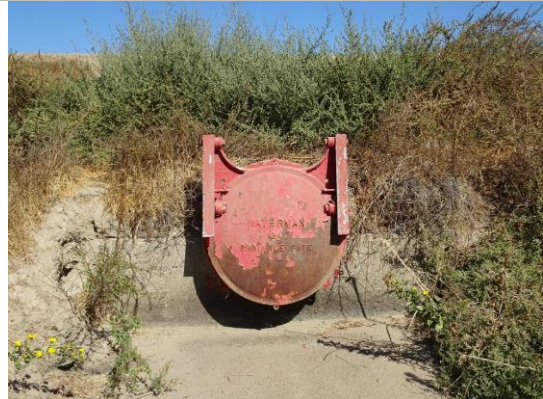
Photo 3 of 3 : UCIP_SP_2022_70665_90721.jpg

WS view: Pipe, flapgate, and headwall at WS toe.

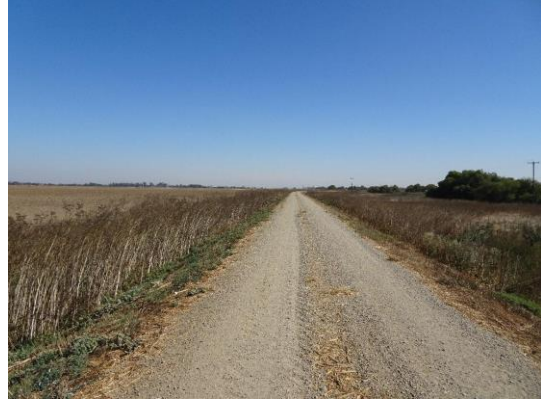
Photo 1 of 3 : UCIP_SP_2022_70667_90738.jpg

Comment Code						
Inspector Comment						
FS_ID:70667 DS_ID:19618 EP_NO: N/A Repair Type: Urgent Crossing Status: Found UCIP Comments: 10/20/2020 Record has been updated from Non-Urgent to Urgent. DWR DMP has found integrity issues, LOF between 5 and 6. Crossing will be monitored until funding becomes available to address. Topography of WS toe has changed over time with sediment build-up preventing proper drainage. At the pipe outlet there is a gradual ground elevation change that causes the water to pond against the flap gate. No permit was found authorizing this encroachment. CVFPB will need to review crossing to determine owner. (B. Singh - GEI, O. Magana - DWR UCIP)04/08/2014 Dense vegetation limits the inspector's visibility to identify signs of pipe failure (leaks) along the slope. Recommend removing vegetation along pipe alignment to conduct proper inspection of structure and appurtenances. (W. Wylie - DWR UCIP) FIELD_STRUCT_DESC: 24-inch corrugated metal (CM) gravity drainage pipe through the levee, 8.0 feet below the crown. Flap gate on the waterside (WS) end. Brass cap No. 80 bench mark (BM) on the headwall on the landside (LS). [Additional Reference(s): DWR Levee Log, 2002, (HLM 7.46). USACE San Joaquin O&M Manual, Unit No. 601, Part No. 1, (SJR601.1), 1967, Revised 25 May 2011, (HLM 7.46)]. FS Date: 10/20/2020

Overview of levee crown, looking US

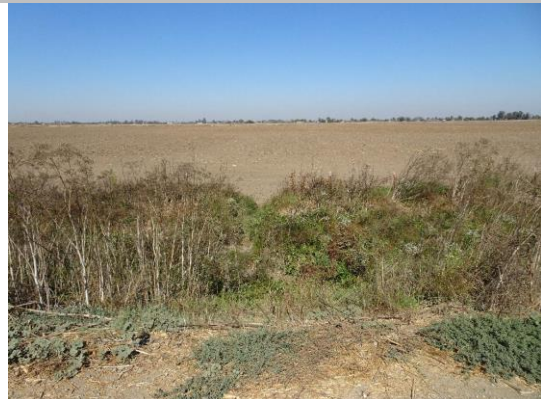
Photo 2 of 3 : UCIP_SP_2022_70667_90739.jpg

LS view: Headwall not visible at LS toe from levee crown due to vegetation

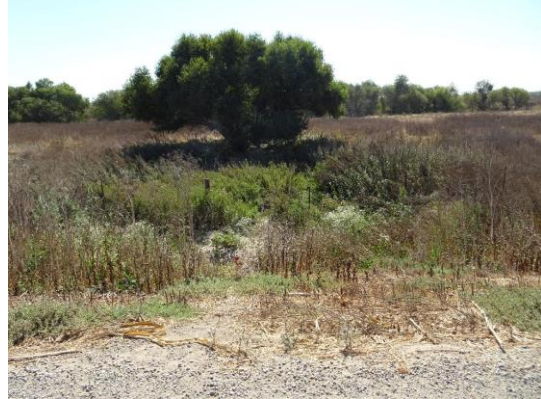
Photo 3 of 3 : UCIP_SP_2022_70667_90740.jpg

WS view: Flapgate visible at WS toe

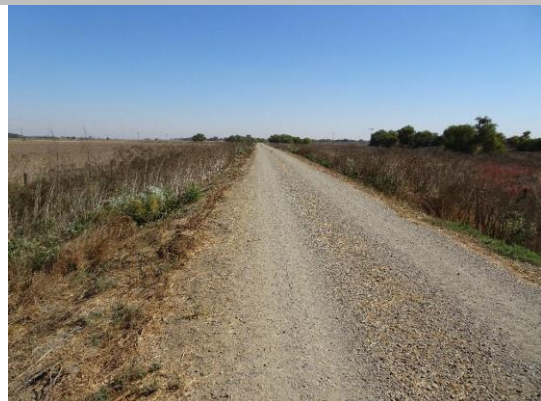
Photo 1 of 3 : UCIP_SP_2022_70668_90744.jpg

Overview of levee crown, looking US

Comment Code					
Inspector Comment					
FS_ID:70668 DS_ID:19619 EP_NO: N/A Repair Type: Urgent Crossing Status: Found UCIP Comments: 10/20/2020 Record has been updated from Non-Urgent to Urgent. Sloughing observed on the LS slope above headwall. DWR DMP has found integrity issues, LOF between 5 and 6. Crossing will be monitored until funding becomes available to address. No permit was found authorizing this encroachment. CVFPB will need to review crossing to determine owner. (B. Singh - GEI, O. Magana - DWR UCIP)04/08/2014 Dense vegetation limits the inspector's visibility to identify signs of pipe failure (leaks) along the slope. Recommend removing vegetation along pipe alignment to conduct proper inspection of structure. (W. Wylie - DWR UCIP) FIELD_STRUCT_DESC: 24-inch corrugated metal (CM) gravity drainage pipe through the levee, 10.0 feet below the crown. Flap gate on the waterside (WS) end. Brass cap No. 80 bench mark (BM) on the headwall on the landside (LS). [Additional Reference(s): DWR Levee Log, 2002, (HLM 7.70). USACE San Joaquin O&M Manual, Unit No. 601, Part No. 1, (SJR601.1), 1967, Revised 25 May 2011, (HLM 7.69)]. FS Date: 10/20/2020

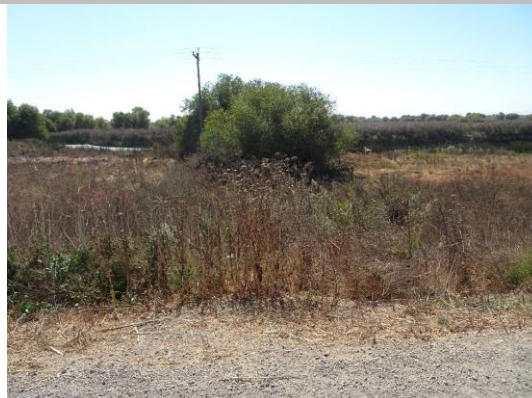
Photo 2 of 3 : UCIP_SP_2022_70668_90746.jpg

WS view: View toward WS toe

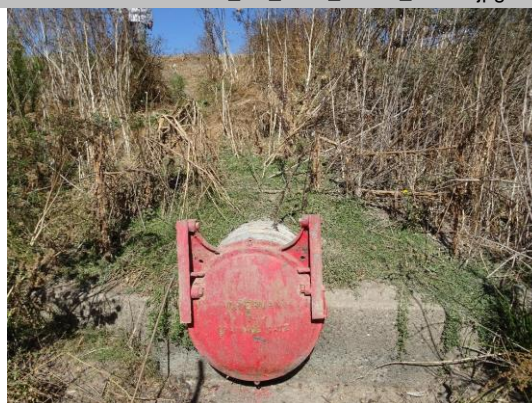
Photo 3 of 3 : UCIP_SP_2022_70668_90743.jpg

WS view: Pipe, headwall, and flapgate on WS toe

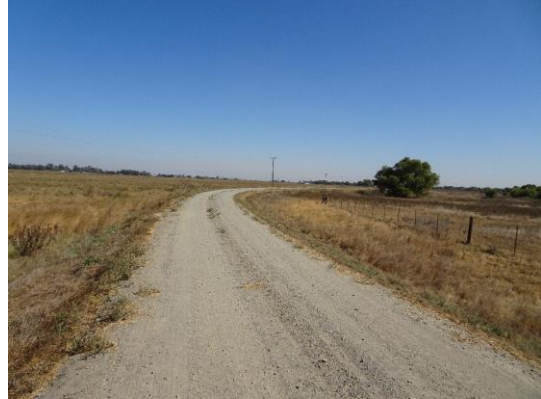
Photo 1 of 3 : UCIP_SP_2022_70669_92400.jpg

Comment Code						
Inspector Comment						
FS_ID:70669 DS_ID:19620 EP_NO: N/A Repair Type: Non-Urgent Crossing Status: Found UCIP Comments: 10/20/2020 Record remains Non-Urgent. DWR DMP has found integrity issues, LOF between 4 and 5. Corrosion in pipe visible on the LS toe. Crossing will be monitored until funding becomes available for rehabilitation. No permit was found authorizing this encroachment. CVFPB will need to review crossing to determine owner. (B. Singh - GEI, O. Magana - DWR UCIP)04/09/2014 Dense vegetation limits the inspector's visibility to identify signs of pipe failure (leaks) along the slope. Recommend removing vegetation along pipe alignment to conduct proper inspection of structure. (W. Wylie - DWR UCIP) FIELD_STRUCT_DESC: 24-inch corrugated metal (CM) gravity drainage pipe through the levee, 8.0 feet below the crown. Flap gate on the waterside (WS) end. Brass cap No. 80 bench mark (BM) on the headwall on the landside (LS). [Additional Reference(s): DWR Levee Log, 2002, (HLM 8.09). USACE San Joaquin O&M Manual, Unit No. 601, Part No. 1, (SJR601.1), 1967, Revised 25 May 2011, (HLM 8.07)]. FS Date: 10/20/2020

Overview of levee crown, looking U/S from several hundred feet away from crossing.

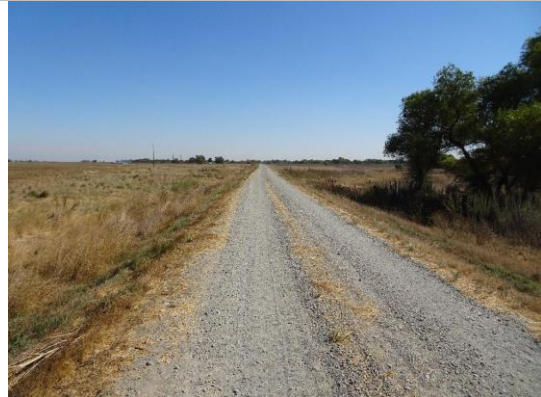
Photo 2 of 3 : UCIP_SP_2022_70669_90750.jpg

Overview of levee crown, looking US

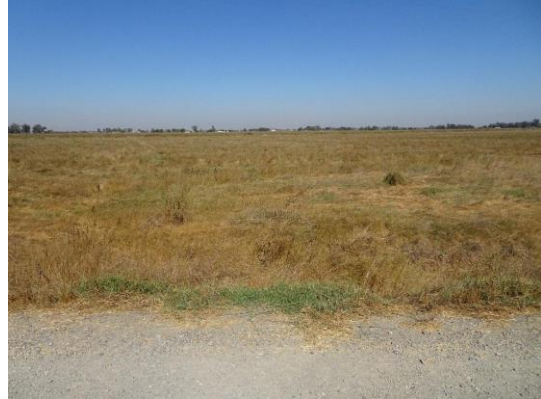
Photo 3 of 3 : UCIP_SP_2022_70669_90751.jpg

LS toe from levee crown

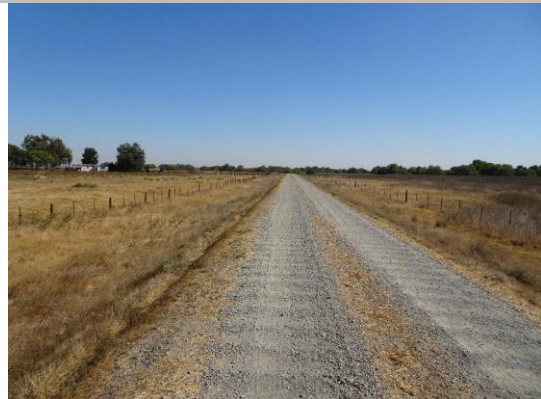
Photo 1 of 3 : UCIP_SP_2022_70670_90757.jpg

FS_ID:70670
DS_ID:19621
EP_NO: N/A
Repair Type: Non-Urgent
Crossing Status: Found
UCIP Comments: 10/20/2020 Record remains Non-Urgent. DWR DMP has found integrity issues, LOF between 4 and 5. Crossing will be monitored until funding becomes available for rehabilitation. No permit was found authorizing this encroachment. CVFPB will need to review crossing to determine owner. (B. Singh - GEI, O. Magana - DWR UCIP)04/09/2014 Dense vegetation limits the inspector's visibility to identify signs of pipe failure (leaks) along the slope. Recommend removing vegetation along pipe alignment to conduct proper inspection of structure. Sediment buildup at landward toe. (W. Wylie - DWR UCIP) FIELD_STRUCT_DESC: 24-inch corrugated metal (CM) gravity drainage pipe through the levee, 9.5 feet below the crown. Flap gate on the waterside (WS) end. Brass cap No. 80 bench mark (BM) on the headwall on the landside (LS). [Additional Reference(s): DWR Levee Log, 2002, (HLM 8.43). USACE San Joaquin O&M Manual, Unit No. 601, Part No. 1, (SJR601.1), 1967, Revised 25 May 2011, (HLM 8.41)]. FS Date: 10/20/2020

Overview of levee crown, looking US

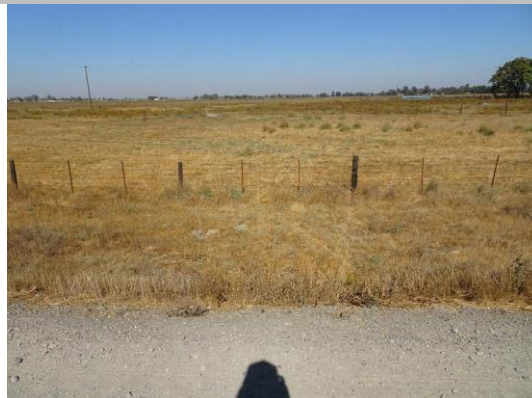
Photo 2 of 3 : UCIP_SP_2022_70670_90758.jpg

LS view: View of LS toe from levee crown

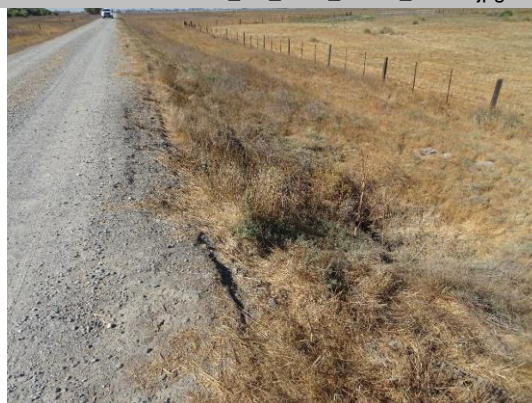
Photo 3 of 3 : UCIP_SP_2022_70670_92416.jpg

LS view: overview of LS slope profile.

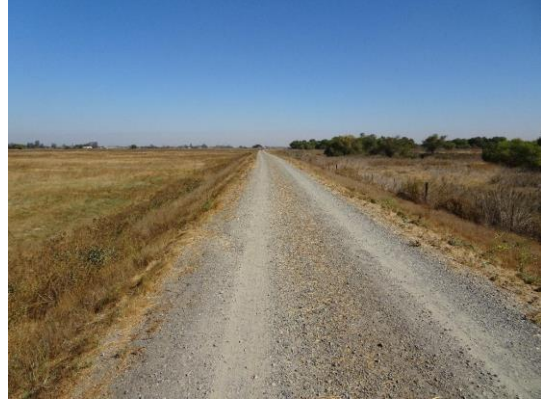
Photo 1 of 3 : UCIP_SP_2022_70672_90770.jpg

Comment Code					
Inspector Comment					
FS_ID:70672 DS_ID:19622 EP_NO: N/A Repair Type: Non-Urgent Crossing Status: Found UCIP Comments: 10/20/2020 Record has been updated from No Action Needed to Non-Urgent. Large burrow hole observed approximately 100 feet downstream of the pipe, on LS shoulder of the levee crown. No permit was found authorizing this encroachment. CVFPB will need to review crossing to determine owner. DWR DMP has not found internal issues, LOF between 1 and 2. Recommend inspection in 5 years. (B. Singh - GEI, O. Magana - DWR UCIP) FIELD_STRUCT_DESC: 24-inch corrugated metal (CM) gravity drainage pipe through the levee, 9.0 feet below the crown. Flap gate on the waterside (WS) end. Brass cap No. 80 bench mark (BM) on the headwall on the landside (LS). [Additional Reference(s): DWR Levee Log, 2002, (HLM 8.62). USACE San Joaquin O&M Manual, Unit No. 601, Part No. 1, (SJR601.1), 1967, Revised 25 May 2011, (HLM 8.61)]. FS Date: 10/20/2020

Overview of levee crown, looking US

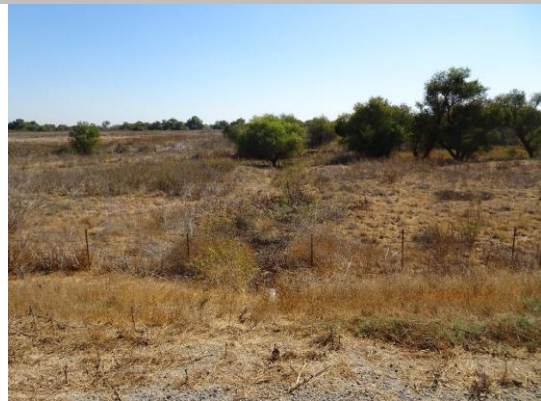
Photo 2 of 3 : UCIP_SP_2022_70672_90772.jpg

WS view: Pipe and flapgate visible on WS toe

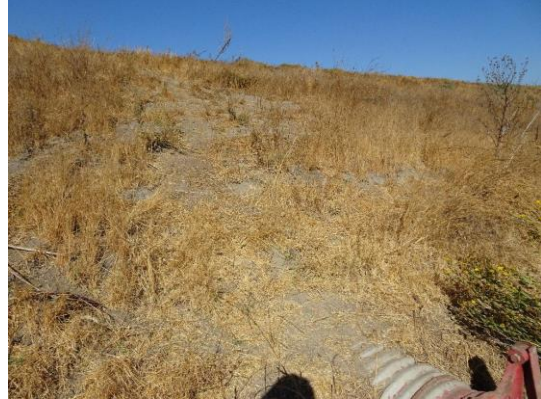
Photo 3 of 3 : UCIP_SP_2022_70672_90767.jpg

WS view: Slope WS pipe and flapgate

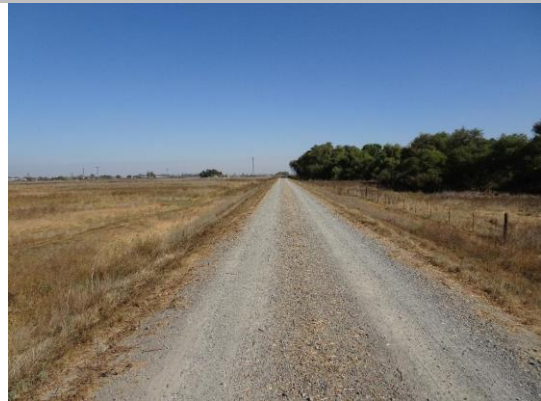
Photo 1 of 3 : UCIP_SP_2022_70673_90778.jpg

FS_ID:70673
DS_ID:19623
EP_NO: N/A
Repair Type: Non-Urgent
Crossing Status: Found
UCIP Comments: 10/20/2020 Record remains Non-Urgent. No permit was found authorizing this encroachment. CVFPB will need to review crossing to determine owner. DWR DMP has not found internal issues, LOF between 1 and 2. Recommend inspection in 5 years. (B. Singh - GEI, O. Magana - DWR UCIP)04/09/2014 Dense vegetation limits the inspector's visibility to identify signs of pipe failure (leaks) along the slope. Recommend removing vegetation along pipe alignment to conduct proper inspection of structure. (W. Wylie - DWR UCIP)
FIELD_STRUCT_DESC: 24-inch corrugated metal (CM) gravity drainage pipe through the levee, 9.1 feet below the crown. Flap gate on the waterside (WS) end. Brass cap No. 80 bench mark (BM) on the headwall on the landside (LS). [Additional Reference(s): DWR Levee Log, 2002, (HLM 8.95). USACE San Joaquin O&M, Unit No. 601, Part No. 1, (SJR601.1), 1967, Revised 25 May 2011, (HLM 8.93)].

Overview of levee crown, looking US

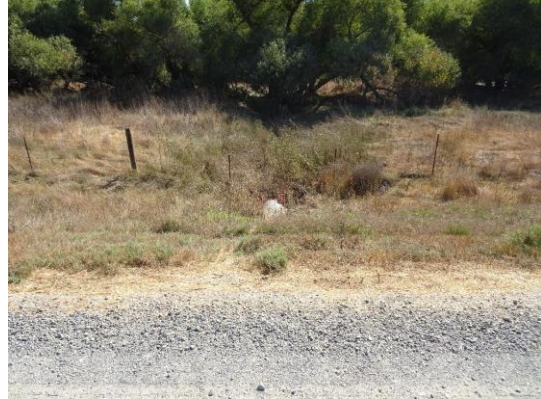
Photo 2 of 3 : UCIP_SP_2022_70673_90780.jpg

WS view: Pipe and flapgate visible at WS toe

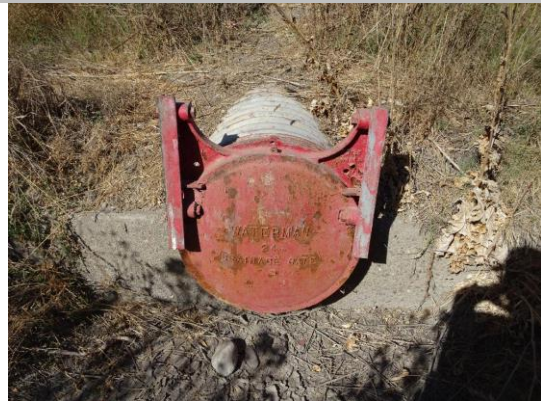
Photo 3 of 3 : UCIP_SP_2022_70673_90776.jpg

WS view: Pipe, flapgate, and headwall at WS toe

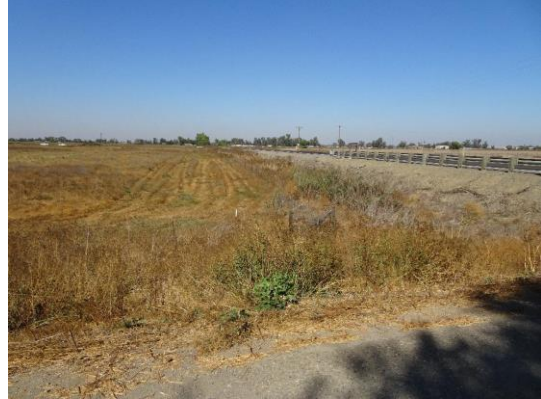
Photo 1 of 3 : UCIP_SP_2022_70675_90789.jpg

Comment Code						
Inspector Comment						
FS_ID:70675 DS_ID:19625 EP_NO: N/A Repair Type: Non-Urgent Crossing Status: Found UCIP Comments: 10/20/2020 Record remains Non-Urgent. As in previous inspection, dense vegetation inhibited proper inspection of the pipe and slope. No permit was found authorizing this encroachment. CVFPB will need to review crossing to determine owner. DWR DMP internal inspection is pending and scheduled for 2021. (B. Singh - GEI, O. Magana - DWR UCIP)04/09/2014 Dense vegetation limits the inspector's visibility to identify signs of pipe failure (leaks) along the slope. Recommend removing vegetation along pipe alignment to conduct proper inspection of structure. Some sediment buildup in pipe. (W. Wylie - DWR UCIP) FIELD_STRUCT_DESC: 36-inch corrugated metal (CM) gravity drainage pipe through the levee, 10.0 feet below the crown. Flap gate on the waterside (WS) end. Brass cap No. 80 bench mark (BM) on the headwall on the landside (LS). [Additional Reference(s): DWR Levee Log, 2002, (HLM 9.01). USACE San Joaquin O&M Manual, Unit No. 601, Part No. 1, (SJR601.1), 1967, Revised 25 May 2011, (HLM 9.00)]. FS Date: 10/20/2020

LS view: View toward LS toe. Headwall not visible due to high vegetation.

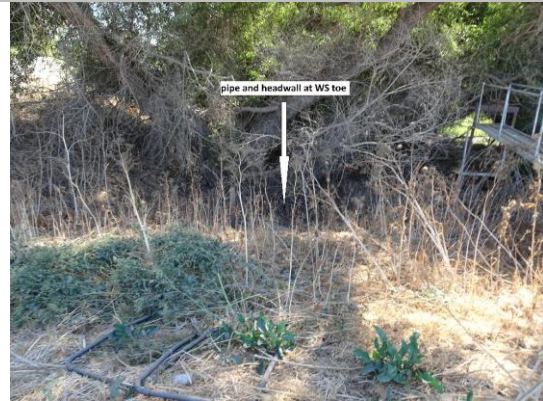
Photo 3 of 3 : UCIP_SP_2022_70675_90791.jpg

WS view: Pipe visible at WS toe, but low accessibility due to vegetation.

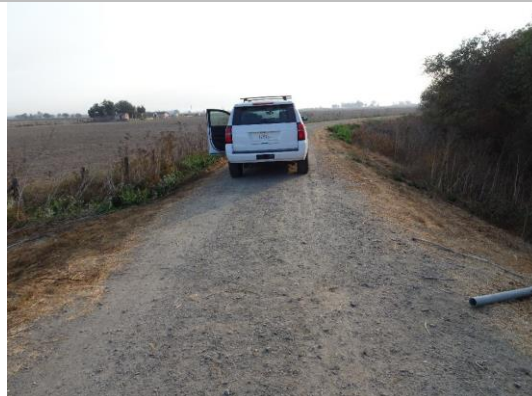
Photo 2 of 3 : UCIP_SP_2022_70676_92421.jpg

Comment Code					
Inspector Comment					
FS_ID:70676 DS_ID:19626 EP_NO: N/A Repair Type: Non-Urgent Crossing Status: Found UCIP Comments: 10/21/2020 Record remains Non-Urgent. Dense vegetation inhibited proper inspection of pipe condition. No permit was found authorizing this encroachment. CVFPB will need to review crossing to determine owner. DWR DMP internal inspection is pending and scheduled for 2021. (B. Singh - GEI, O. Magana - DWR UCIP)04/09/2014 Dense vegetation limits the inspector's visibility to identify signs of pipe failure (leaks) along the slope. Recommend removing vegetation along pipe alignment to conduct proper inspection of structure. (W. Wylie - DWR UCIP) FIELD_STRUCT_DESC: 24-inch corrugated metal (CM) gravity drainage pipe through the levee, 10.0 feet below the crown. Flap gate on the waterside (WS) end. Brass cap No. 80 bench mark (BM) on the headwall on the landside (LS). [Additional Reference(s): DWR Levee Log, 2002, (HLM 9.03). USACE San Joaquin O&M Manual, Unit No. 601, Part No. 1, (SJR601.1), 1967, Revised 25 May 2011, (HLM 9.03)]. FS Date: 10/21/2020

Overview of levee crown looking upstream.

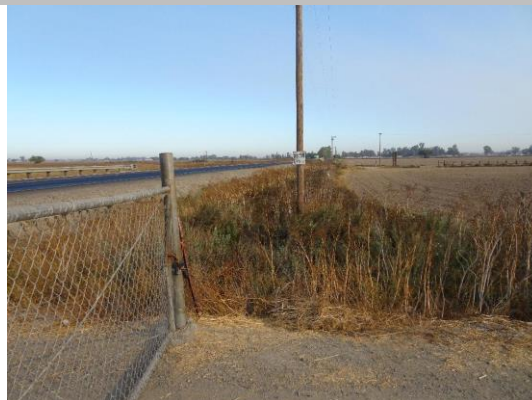
Photo 3 of 3 : UCIP_SP_2022_70676_90907.jpg

LS view: overview of LS

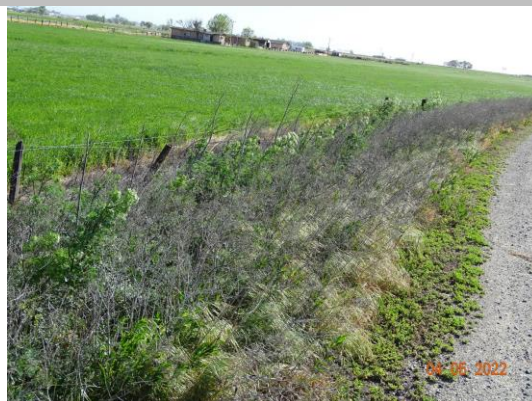
Photo 1 of 1 : SP_2022_NA0010_118_129_20220412_00304.jpg

LM Start	8.99	Rating **	U	Issue No.	129
LM End	9.64	Issue Type +	Ma	Location *	LS
Category	Earthen Levee			GPS Latitude/Longitude	
				Start	End
Item	Vegetation			37.297497 °	37.294875 °
				-120.851069 °	-120.840601 °
DWR ID	DWR_NA0010_01_s_2022_129				
Comment Code					
V1 : Control annual grass and weeds on the levee slopes and easements.					
Inspector Comment

View of vegetation on the landside slope. (Spring 2022)

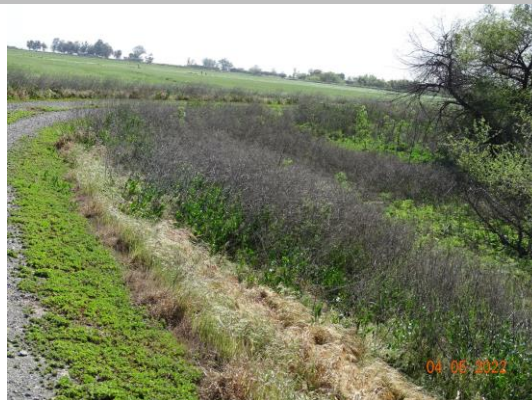
Photo 1 of 1 : SP_2022_NA0010_118_130_20220412_00305.jpg

LM Start	9.00	Rating **	U	Issue No.	130
LM End	9.13	Issue Type +	Ma	Location *	WS
Category	Earthen Levee			GPS Latitude/Longitude	
				Start	End
Item	Vegetation			37.297503 °	37.296435 °
				-120.850882 °	-120.849015 °
DWR ID	DWR_NA0010_01_s_2022_130				
Comment Code					
V1 : Control annual grass and weeds on the levee slopes and easements.					
Inspector Comment

Looking upstream along the waterside slope. (Spring 2022)

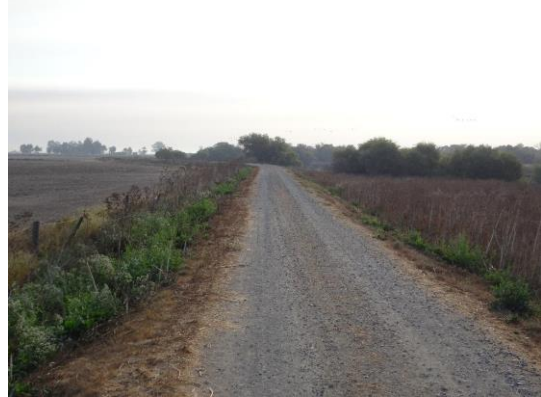
Photo 1 of 3 : UCIP_SP_2022_70677_90910.jpg

Comment Code					
Inspector Comment					
FS_ID:70677 DS_ID:19627 EP_NO: N/A Repair Type: Urgent Crossing Status: Found UCIP Comments: 10/21/2020 Record has been updated from Non-Urgent to Urgent. DWR DMP has found integrity issues, LOF between 5 and 6. Scouring observed about 2 feet downstream of pipe at WS toe. Crossing will be monitored until funding becomes available to address. No permit was found authorizing this encroachment. CVFPB will need to review crossing to determine owner. (B. Singh - GEI, O. Magana - DWR UCIP)04/09/2014 Dense vegetation limits the inspector's visibility to identify signs of pipe failure (leaks) along the slope. Recommend removing vegetation along pipe alignment to conduct proper inspection of structure. (W. Wylie - DWR UCIP) FIELD_STRUCT_DESC: 24-inch corrugated metal (CM) gravity drainage pipe through the levee, 8.6 feet below the crown. Concrete drop inlet at the landside (LS) toe. Flap gate on the waterside (WS) end. Brass cap No. 80 bench mark (BM) on the headwall on the LS. [Additional Reference(s): DWR Levee Log, 2002, (HLM 9.39). USACE San Joaquin O&M Manual, Unit No. 601, Part No. 1, (SJR601.1), 1967, Revised 25 May 2011, (HLM 9.37)]. FS Date: 10/21/2020

Overview of levee crown

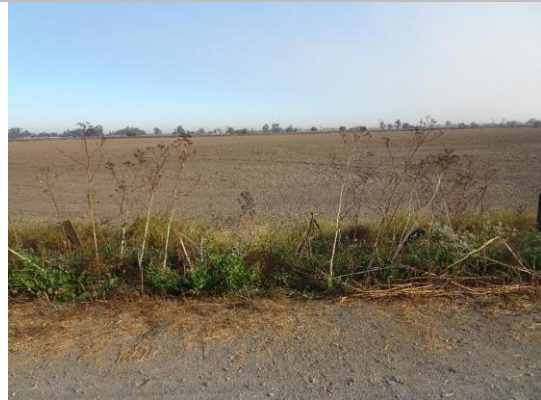
Photo 2 of 3 : UCIP_SP_2022_70677_90912.jpg

LS view: overview of LS

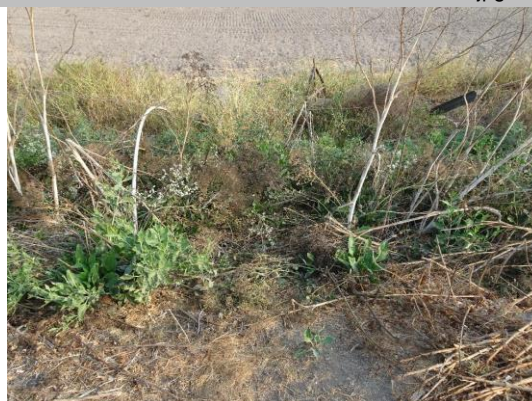
Photo 3 of 3 : UCIP_SP_2022_70677_90911.jpg

LS view: View of LS slope from levee crown

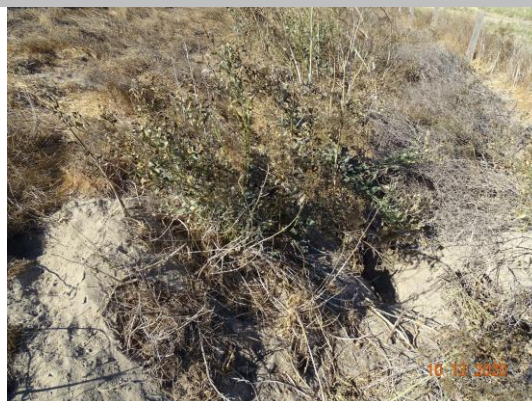
Photo 1 of 1 : SP_2022_NA0010_118_101_20220308_00008.jpg

LM Start	9.56	Rating **	M	Issue No.	101
LM End	9.56	Issue Type +	Ma	Location *	LS
Category	Earthen Levee			GPS Latitude/Longitude	
				Start	End
Item	Animal Control			37.295541 °	37.295541 °
				-120.841739 °	-120.841739 °
DWR ID	DWR_NA0010_01_f_2020_101				
Comment Code					
A1 : Exterminate rodents and backfill and compact or grout burrows.					
Inspector Comment

Rodent burrows in the landside slope. (Fall 2020)

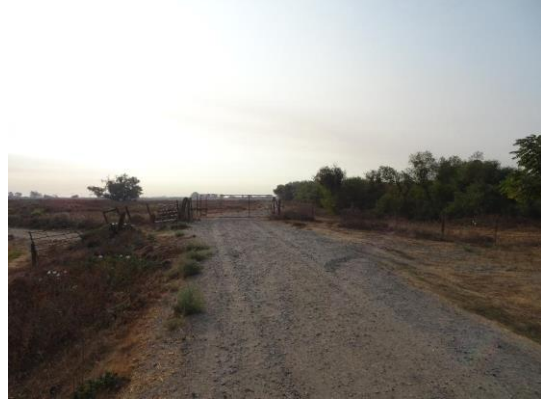
Photo 1 of 3 : UCIP_SP_2022_70678_90915.jpg

Comment Code					
Inspector Comment					
FS_ID:70678 DS_ID:19628 EP_NO: N/A Repair Type: Non-Urgent Crossing Status: Found UCIP Comments: 10/21/2020 Record has been updated from No Action Needed to Non-Urgent. No permit was found authorizing this encroachment. CVFPB will need to review crossing to determine owner. DWR DMP has not found internal issues, LOF between 1 and 2. Recommend inspection in 5 years. (B. Singh - GEI, O. Magana - DWR UCIP) FIELD_STRUCT_DESC: 24-inch corrugated metal (CM) gravity drainage pipe through the levee, 4.5 feet below the crown. Flap gate on the waterside (WS) end. Brass cap No. 80 bench mark (BM) on the headwall on the landside (LS). [Additional Reference(s): DWR Levee Log, 2002, (HLM 9.68). USACE San Joaquin O&M Manual, Unit No. 601, Part No. 1, (SJR601.1), 1967, Revised 25 May 2011, (HLM 9.67)]. FS Date: 10/21/2020

Overview of levee crown

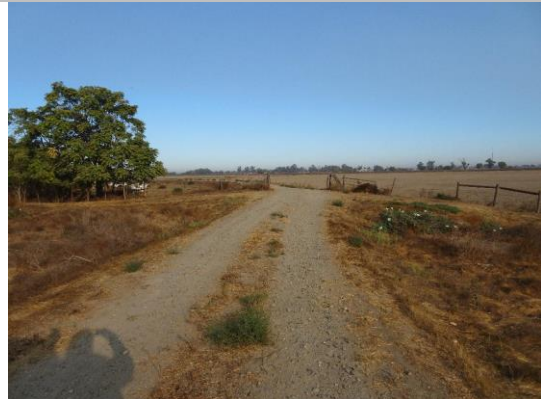
Photo 2 of 3 : UCIP_SP_2022_70678_92422.jpg

Overview of levee crown looking downstream towards pipe crossing.

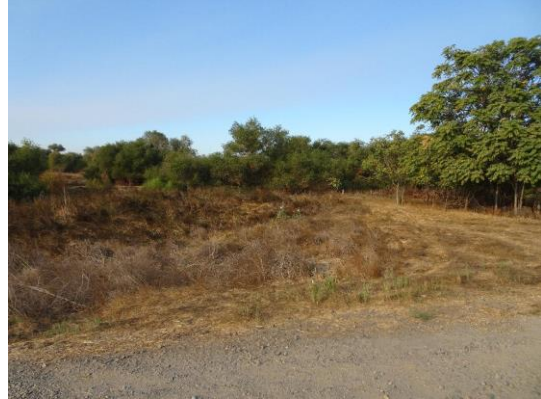
Photo 3 of 3 : UCIP_SP_2022_70678_90916.jpg

WS view: overview of WS

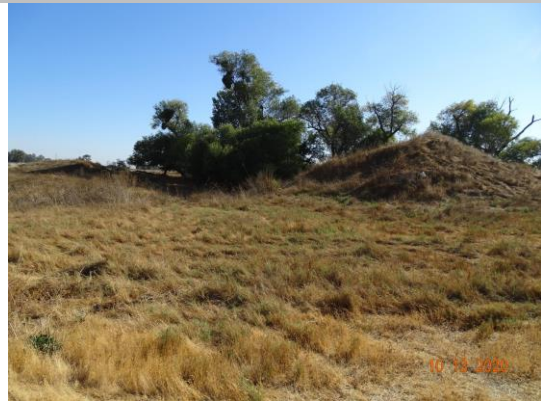
Photo 1 of 1 : SP_2022_NA0010_118_112_20220308_00014.jpg

LM Start	9.89	Rating **	A/W	Issue No.	112
LM End	9.90	Issue Type +	Ma	Location *	CR
Category	Earthen Levee			GPS Latitude/Longitude	
				Start	End
Item	Erosion / Bank Caving			37.291796 °	37.291581 °
				-120.839497 °	-120.839718 °
DWR ID	DWR_NA0010_01_f_2017_112				
Comment Code					
E1 : Note and monitor erosion site.					
Inspector Comment					
Landowner degraded levee in the 1970's because water on LS was flooding his property. Landowner has prevented efforts to restore levee. LMA has stated that no water from the waterside of the levee has ever backed up through the degraded levee and caused flooding.

Looking east at the levee breach. (Fall 2020)

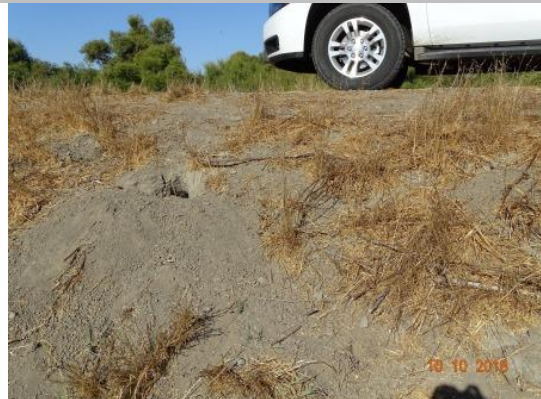
Photo 1 of 1 : SP_2022_NA0010_118_120_20220308_00021.jpg

LM Start	9.94	Rating **	U	Issue No.	120
LM End	9.97	Issue Type +	Ma	Location *	LS
Category	Earthen Levee			GPS Latitude/Longitude	
				Start	End
Item	Animal Control			37.290994 °	37.290673 °
				-120.839758 °	-120.839988 °
DWR ID	DWR_NA0010_01_f_2018_120				
Comment Code					
A3 : No rodents visible, but rodent burrows visible; need to backfill and compact or grout burrows.					
Inspector Comment					
Rodent burrows observed in this section with large amount of material displaced.

View of rodent burrow in the landside slope. (Fall 2018)

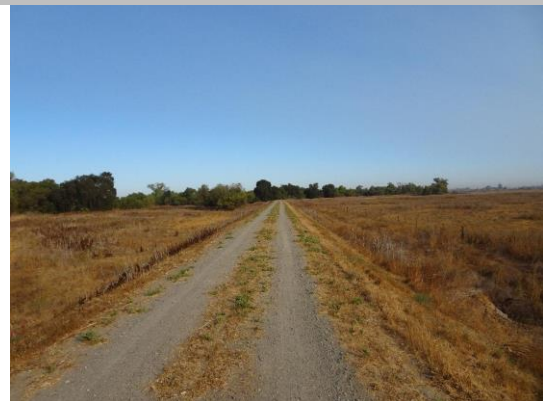
Photo 1 of 3 : UCIP_SP_2022_70681_90922.jpg

Comment Code						
Inspector Comment						
FS_ID:70681						
DS_ID:19629						
EP_NO: N/A						
Repair Type: Non-Urgent						
Crossing Status: Found						
UCIP Comments: 10/21/2020 Record remains Non-Urgent. No permit was found authorizing this encroachment. CVFPB will need to review crossing to determine owner. DWR DMP has not found internal issues, LOF between 1 and 2. Recommend inspection in 5 years. (B. Singh - GEI, O. Magana - DWR UCIP)04/09/2014 Dense vegetation blocks waterward and landward toes Recommend removing vegetation from both toes. Also sediment buildup in pipe visible from landward side. (W. Wylie - UCIP DMP)						
FIELD_STRUCT_DESC: 24-inch corrugated metal (CM) gravity drainage pipe through the levee, 9.0 feet below the crown. Flap gate on the waterside (WS) end. Brass cap No. 69 bench mark (BM) on the headwall on the landside (LS). [Additional Reference(s): DWR Levee Log, 2002, (HLM 10.24). USACE San Joaquin O&M Manual, Unit No. 601, Part No. 1, (SJR601.1), 1967, Revised 25 May 2011, (HLM 10.23)].

Overview of levee crown
