**Flood Control Project Maintenance
Levee Inspections**

Maintenance Issue Types Only, Levee Inspection Report By Mile - Spring 2022

Lower San Joaquin Levee District

Waterway	Bank	Unit Miles	Inspection Start/End	Inspector
Unit No. 01 San Joaquin River	Right	22.52	04/05/2022 04/05/2022	Corey Fujitani

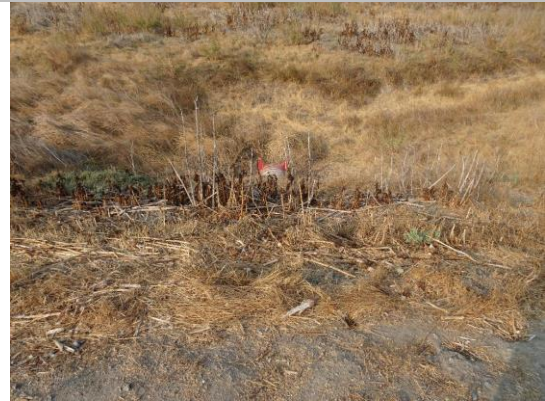
Photo 2 of 3 : UCIP_SP_2022_70681_90923.jpg

Comment Code						
Inspector Comment						
FS_ID:70681						
DS_ID:19629						
EP_NO: N/A						
Repair Type: Non-Urgent						
Crossing Status: Found						
UCIP Comments: 10/21/2020 Record remains Non-Urgent. No permit was found authorizing this encroachment. CVFPB will need to review crossing to determine owner. DWR DMP has not found internal issues, LOF between 1 and 2. Recommend inspection in 5 years. (B. Singh - GEI, O. Magana - DWR UCIP)04/09/2014 Dense vegetation blocks waterward and landward toes Recommend removing vegetation from both toes. Also sediment buildup in pipe visible from landward side. (W. Wylie - UCIP DMP)						
FIELD_STRUCT_DESC: 24-inch corrugated metal (CM) gravity drainage pipe through the levee, 9.0 feet below the crown. Flap gate on the waterside (WS) end. Brass cap No. 69 bench mark (BM) on the headwall on the landside (LS). [Additional Reference(s): DWR Levee Log, 2002, (HLM 10.24). USACE San Joaquin O&M Manual, Unit No. 601, Part No. 1, (SJR601.1), 1967, Revised 25 May 2011, (HLM 10.23)].

WS view: Pipe and flapgate visible at WS toe

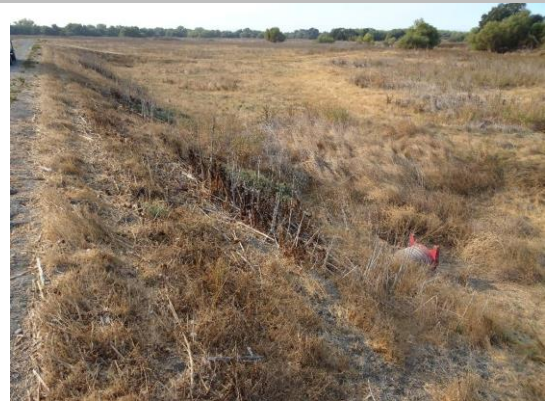
Photo 3 of 3 : UCIP_SP_2022_70681_90926.jpg

WS view: WS slope profile

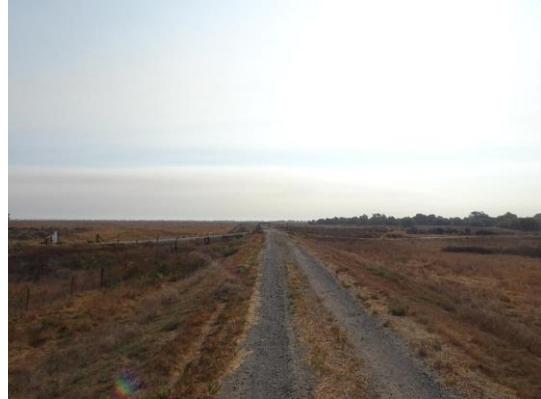
Photo 1 of 3 : UCIP_SP_2022_70682_92750.jpg

Comment Code					
Inspector Comment					
FS_ID:70682 DS_ID:19630 EP_NO: N/A Repair Type: Non-Urgent Crossing Status: Found UCIP Comments: 10/21/2020 Record has been updated from No Action Needed to Non-Urgent. No permit was found authorizing this encroachment. CVFPB will need to review crossing to determine owner. DWR DMP has not found internal issues, LOF between 1 and 2. Recommend inspection in 5 years. (B. Singh - GEI, O. Magana - DWR UCIP) FIELD_STRUCT_DESC: 24-inch corrugated metal (CM) gravity drainage pipe through the levee, 7.0 feet below the crown. Flap gate on the waterside (WS) end. Brass cap No. 68 bench mark (BM) on the headwall on the landside (LS). [Additional Reference(s): DWR Levee Log, 2002, (HLM 10.73). USACE San Joaquin O&M Manual, Unit No. 601, Part No. 1, (SJR601.1), 1967, Revised 25 May 2011, (HLM 10.72)]. FS Date: 10/21/2020

Overview of levee crown, looking upstream towards crossing.

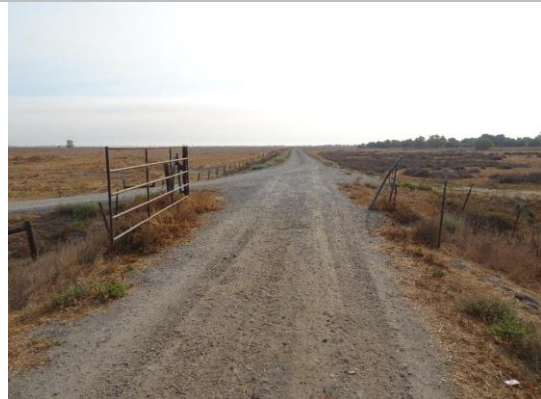
Photo 2 of 3 : UCIP_SP_2022_70682_90999.jpg

Overview of levee crown looking upstream

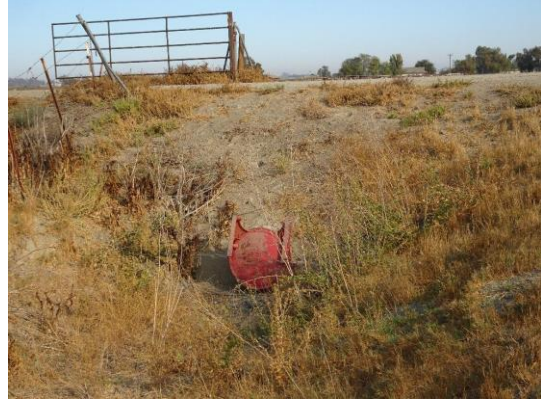
Photo 3 of 3 : UCIP_SP_2022_70682_91001.jpg

WS view: Pipe and flapgate visible at WS toe

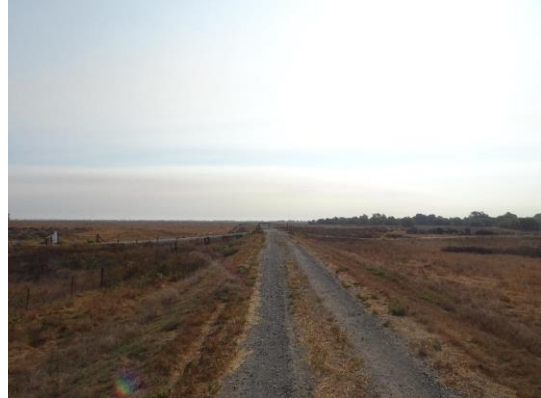
Photo 1 of 3 : UCIP_SP_2022_70683_92770.jpg

FS_ID:70683
DS_ID:19631
EP_NO: N/A
Repair Type: Non-Urgent
Crossing Status: Found
UCIP Comments: 10/21/2020 Record has been updated from No Action Needed to Non-Urgent. DWR DMP has found integrity issues, LOF between 4 and 5. Crossing will be monitored until funding becomes available for rehabilitation. No permit was found authorizing this encroachment. CVFPB will need to review crossing to determine owner. Pipe material changes from CMP on the WS to concrete on the LS. (B. Singh - GEI, O. Magana - DWR UCIP)
FIELD_STRUCT_DESC: 24-inch corrugated metal (CM) gravity drainage pipe through the levee, 7.0 feet below the crown. Flap gate on the waterside (WS) end. Brass cap No. 67 bench mark (BM) on the headwall on the landside (LS). Pipe material changes from CMP on the WS to concrete on the LS. [Additional Reference(s): DWR Levee Log, 2002, (HLM 10.74). USACE San Joaquin O&M Manual, Unit No. 601, Part No. 1, (SJR601.1), 1967, Revised 25 May 2011, (HLM 10.72)].

Overview of levee crown looking upstream towards crossings.

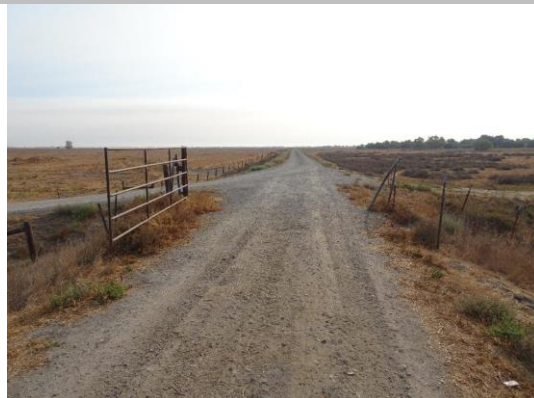
Photo 2 of 3 : UCIP_SP_2022_70683_91009.jpg

Overview of levee crown looking upstream

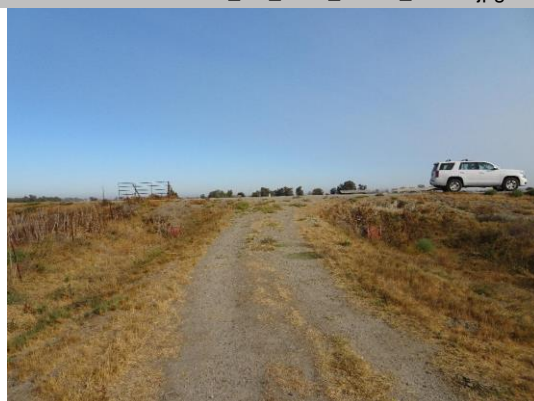
Photo 3 of 3 : UCIP_SP_2022_70683_92766.jpg

WS view: ramp located on WS with two crossing on either side. This crossing is located on the right side.

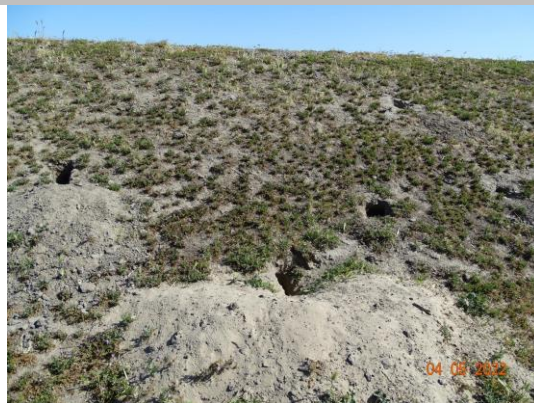
Photo 1 of 1 : SP_2022_NA0010_118_133_20220412_00306.jpg

LM Start	10.90	Rating **	U	Issue No.	133
LM End	10.90	Issue Type +	Ma	Location *	WS
Category	Earthen Levee			GPS Latitude/Longitude	
				Start	End
Item	Animal Control			37.282911 °	37.282911 °
				-120.829665 °	-120.829665 °
DWR ID	DWR_NA0010_01_s_2022_133				
Comment Code					
A3 : No rodents visible, but rodent burrows visible; need to backfill and compact or grout burrows.					
Inspector Comment

View of rodent burrows on the waterside slope. (Spring 2022)

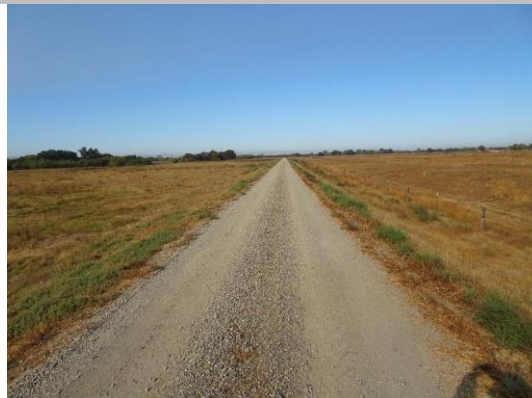
Photo 1 of 3 : UCIP_SP_2022_70684_90929.jpg

Comment Code						
Inspector Comment						
FS_ID:70684						
DS_ID:19632						
EP_NO: N/A						
Repair Type: Non-Urgent						
Crossing Status: Found						
UCIP Comments: 10/21/2020 Record remains Non-Urgent. No permit was found authorizing this encroachment. CVFPB will need to review crossing to determine owner. DWR DMP has not found internal issues, LOF between 1 and 2. Recommend inspection in 5 years. Dense vegetation previously recorded in the 2014 UCIP inspection has been cleared. (B. Singh - GEI, O. Magana - DWR UCIP)04/09/2014 Dense vegetation blocks landward headwall. Recommend removing excess vegetation on landward toe. (W. Wylie - DWR UCIP)						
FIELD_STRUCT_DESC: 24-inch corrugated metal (CM) gravity drainage pipe through the levee, 6.0 feet below the crown. Flap gate on the waterside (WS) end. Brass cap No. 66 bench mark (BM) on the headwall on the landside (LS). [Additional Reference(s): DWR Levee Log, 2002, (HLM 11.02). USACE San Joaquin O&M Manual, Unit No. 601, Part No. 1, (SJR601.1), 1967, Revised 25 May 2011, (HLM 11.00)].

Overview of levee crown looking upstream

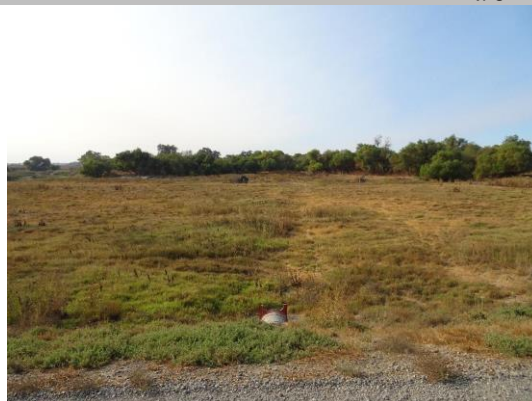
Photo 2 of 3 : UCIP_SP_2022_70684_90930.jpg

WS view: overview of WS

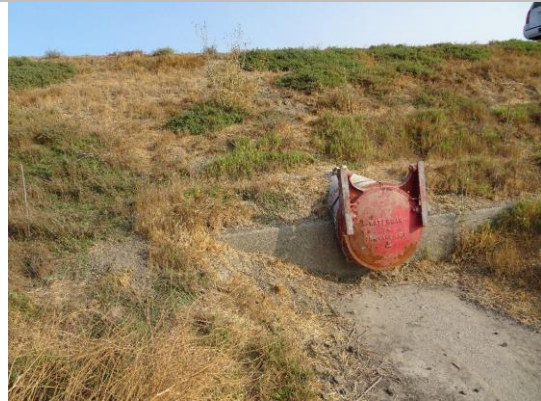
Photo 3 of 3 : UCIP_SP_2022_70684_90932.jpg

WS view: overview of WS slope

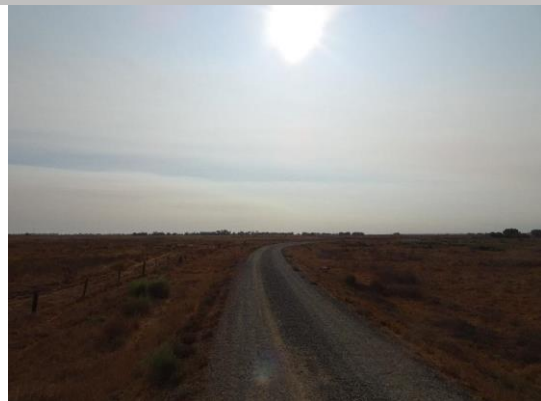
Photo 1 of 3 : UCIP_SP_2022_70685_92800.jpg

FS_ID:70685
 DS_ID:19633
 EP_NO: N/A
 Repair Type: Non-Urgent
 Crossing Status: Found
 UCIP Comments: 10/21/2020 Record has been updated from No Action Needed to Non-Urgent. No permit was found authorizing this encroachment. CVFPB will need to review crossing to determine owner. DWR DMP has not found internal issues, LOF between 1 and 2. Recommend inspection in 5 years. (B. Singh - GEI, O. Magana - DWR UCIP)
 FIELD_STRUCT_DESC: 24-inch corrugated metal (CM) gravity drainage pipe through the levee, 5.0 feet below the crown. Flap gate on the waterside (WS) end. Brass cap No. 65 bench mark (BM) on the headwall on the landside (LS). [Additional Reference(s): DWR Levee Log, 2002, (HLM 11.20). USACE San Joaquin O&M Manual, Unit No. 601, Part No. 1, (SJR601.1), 1967, Revised 25 May 2011, (HLM 11.18)].
 FS Date: 10/21/2020

Overview of levee curve towards pipe crossing, looking upstream

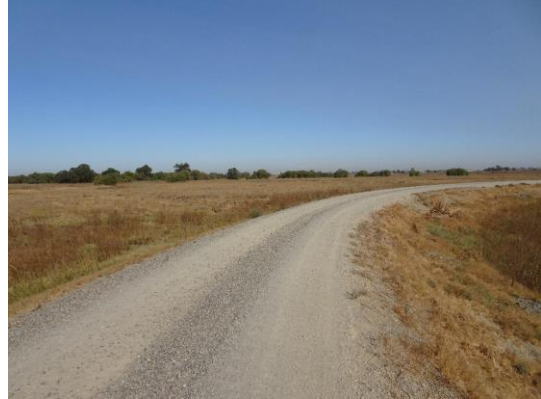
Photo 1 of 3 : UCIP_SP_2022_70686_90940.jpg

Comment Code						
Inspector Comment						
FS_ID:70686						
DS_ID:19814						
EP_NO: N/A						
Repair Type: Non-Urgent						
Crossing Status: Found						
UCIP Comments: 10/21/2020 Record has been updated from No						
Action Needed to Non-Urgent. Steep slopes prevented further						
inspection of the WS and LS toes. No permit was found authorizing this						
encroachment. CVFPB will need to review crossing to determine owner.						
DWR DMP has not found internal issues, LOF between 1 and 2.						
Recommend inspection in 5 years. (B. Singh - GEI, O. Magana - DWR						
UCIP)						
FIELD_STRUCT_DESC: 24-inch corrugated metal (CM) gravity						
drainage pipe through the levee, 12.0 feet below the crown. Two metal						
cutoff walls. Flap gate, concrete saddle, and apron on the waterside						
(WS) end. Concrete headwall on the landside (LS) end. [Additional						
Reference(s): DWR Levee Log, 2002. USACE San Joaquin O&M

Overview of levee crown looking upstream.

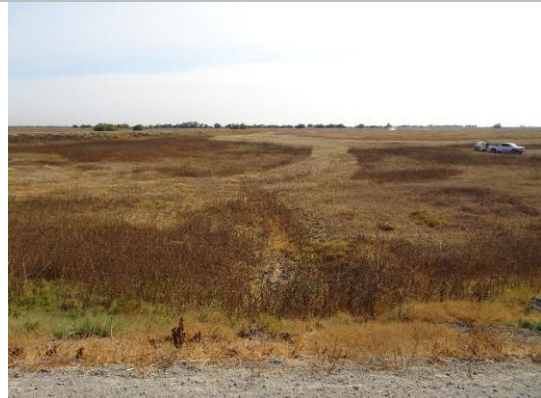
Photo 2 of 3 : UCIP_SP_2022_70686_90941.jpg

LS view: overview of LS

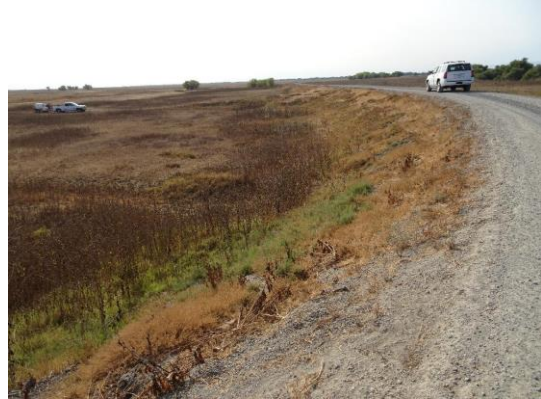
Photo 3 of 3 : UCIP_SP_2022_70686_92834.jpg

LS view: profile view of LS slope.

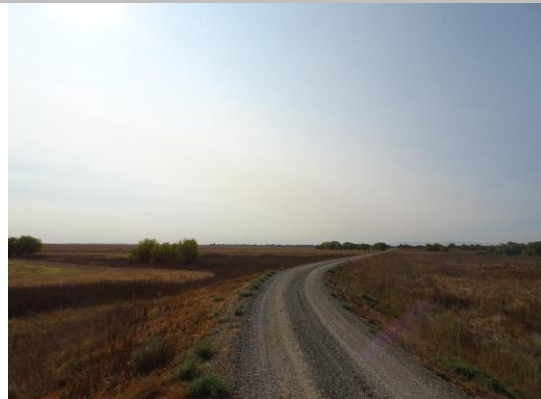
Photo 1 of 3 : UCIP_SP_2022_70687_92836.jpg

FS_ID:70687
DS_ID:19634
EP_NO: N/A
Repair Type: Non-Urgent
Crossing Status: Found
UCIP Comments: 10/21/2020 Record remains Non-Urgent. Dense vegetation inhibited inspection of pipe and headwall on the LS toe. DWR DMP has found integrity issues, LOF between 4 and 5. Unable to locate pipe inlet on along the LS toe. Crossing will be monitored until funding becomes available for rehabilitation. No permit was found authorizing this encroachment. CVFPB will need to review crossing to determine owner. (B. Singh - GEI, O. Magana - DWR UCIP)04/25/2014 Need to contact owner--landward side has been buried. It appears that soil was removed from levee toe, immediately upstream, and used to pile soil at landward side at crossing. (O. Magana - DWR UCIP)
FIELD_STRUCT_DESC: 24-inch corrugated metal (CM) gravity drainage pipe through the levee, 10.0 feet below the crown. Flap gate on the waterside (WS) end. Brass cap No. 62 bench mark (BM) on the headwall on the landside (LS). [Additional Reference(s): DWR Levee Log, 2002, (HLM 11.48). USACE San Joaquin O&M Manual, Unit No. 601, Part No. 1, (SJR601.1), 1967, Revised 25 May 2011, (HLM 11.48)].

Overview of levee crown looking upstream towards pipe crossing, photo 1 of 2.

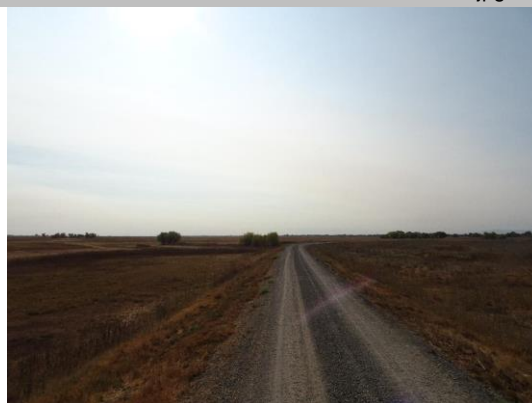
Photo 2 of 3 : UCIP_SP_2022_70687_90946.jpg

Overview of levee crown looking upstream towards pipe crossing, photo 2 of 2.

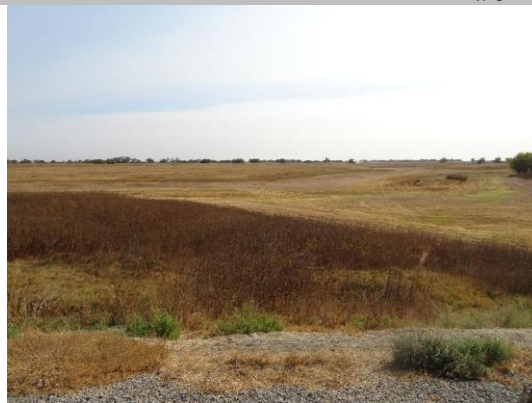
Photo 3 of 3 : UCIP_SP_2022_70687_90949.jpg

LS view: overview of LS.

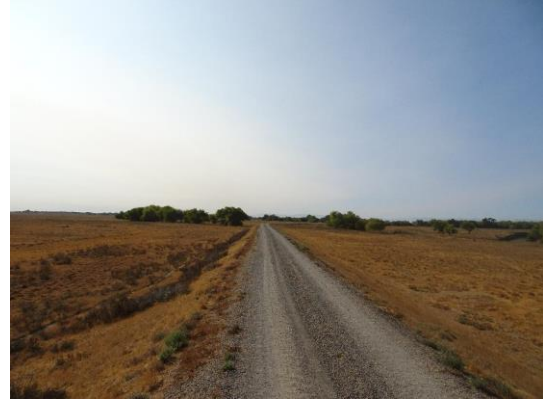
Photo 1 of 3 : UCIP_SP_2022_70688_90950.jpg

Comment Code						
Inspector Comment						
FS_ID:70688 DS_ID:19635 EP_NO: N/A Repair Type: Non-Urgent Crossing Status: Found UCIP Comments: 10/21/2020 Record remains Non-Urgent. DWR DMP geophysics study found evidence of pipe at 37.269697, -120.826430 (modified levee mile coordinates 37.269657, -120.826471 using UCIP calculator). Pipe and flap gate previously found on the WS toe were covered by dry vegetation preventing proper UCIP inspection. Recommend removal of excess vegetation to conduct a proper inspection of this structure through the levee. The pipe inlet and concrete headwall are buried on the LS toe. No permit was found authorizing this encroachment. CVFPB will need to review crossing to determine owner. (B. Singh - GEI, O. Magana - DWR UCIP)04/25/2014 Crossing is non-functional --landward side is buried. Debris found on landward side (channel). Dense vegetation found on waterward slope. Recommend contacting owner to determine status of crossing. If crossing is no longer used need to coordinate with CVFPB for proper abandonment. (O. Magana - DWR UCIP) FIELD_STRUCT_DESC: 24-inch corrugated metal (CM) gravity drainage pipe through the levee, 17.0 feet below the crown. Flap gate on the waterside (WS) end. Brass cap No. 61 bench mark (BM) on the headwall on the landside (LS). [Additional Reference(s): DWR Levee Log, 2002, (HLM 11.77). USACE San Joaquin O&M Manual, Unit No. 601, Part No. 1, (SJR601.1), 1967, Revised 25 May 2011, (HLM 11.76)]. FS Date: 10/21/2020

Overview of levee crown

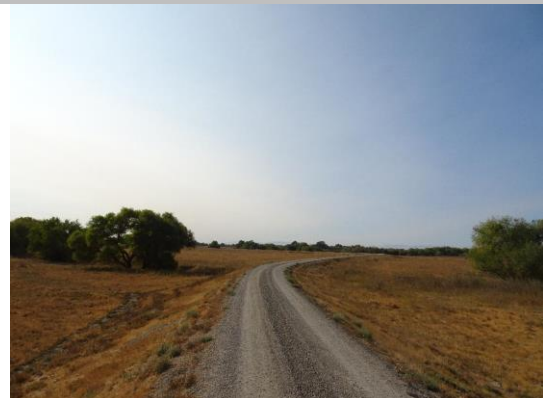
Photo 2 of 3 : UCIP_SP_2022_70688_92838.jpg

Overview of levee crown looking upstream towards pipe.

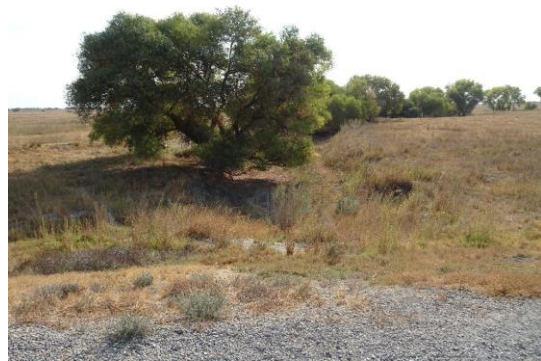
Photo 3 of 3 : UCIP_SP_2022_70688_90953.jpg

LS view: overview of LS

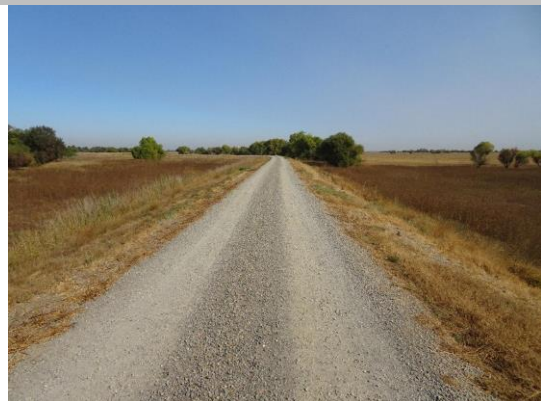
Photo 1 of 3 : UCIP_SP_2022_70689_90956.jpg

FS_ID:70689
DS_ID:19636
EP_NO: N/A
Repair Type: Non-Urgent
Crossing Status: Found
UCIP Comments: 10/21/2020 Record remains Non-Urgent. Dense vegetation inhibited proper inspection of the pipe on the LS and WS toes. No permit was found authorizing this encroachment. CVFPB will need to review crossing to determine owner. DWR DMP internal inspection is pending and scheduled for 2021. (B. Singh - GEI, O. Magana - DWR UCIP)04/25/2014 Crossing is non-functional -- landward side is buried. Dense vegetation found on waterward slope. Recommend contacting owner to determine status of crossing. If crossing is no longer used need to coordinate with CVFPB for proper abandonment. (O. Magana - DWR UCIP)
FIELD_STRUCT_DESC: 24-inch corrugated metal (CM) gravity drainage pipe through the levee, 12.4 feet below the crown. Flap gate on the waterside (WS) end. Brass cap No. 60 bench mark (BM) on the headwall on the landside (LS). [Additional Reference(s): DWR Levee Log, 2002, (HLM 12.12). USACE San Joaquin O&M Manual, Unit No. 601, Part No. 1, (SJR601.1), 1967, Revised 25 May 2011, (HLM 12.11)].

Overview of levee crown looking upstream.

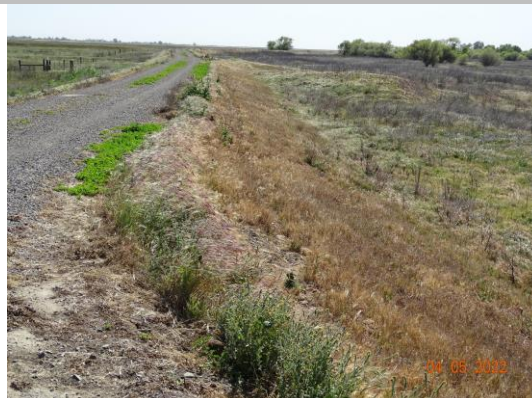
Photo 1 of 1 : SP_2022_NA0010_118_138_20220412_00309.jpg

LM Start	12.62	Rating **	M	Issue No.	138
LM End	12.81	Issue Type +	Ma	Location *	WS
Category	Earthen Levee			GPS Latitude/Longitude	
				Start	End
Item	Vegetation			37.258975 °	37.258036 °
				-120.826389 °	-120.823149 °
DWR ID	DWR_NA0010_01_s_2022_138				
Comment Code					
V1 : Control annual grass and weeds on the levee slopes and easements.					
Inspector Comment

View of the waterside slope looking upstream. (Spring 2022)

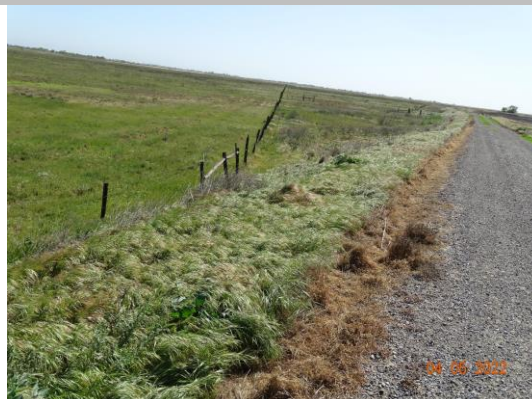
Photo 1 of 1 : SP_2022_NA0010_118_137_20220412_00310.jpg

LM Start	12.62	Rating **	M	Issue No.	137
LM End	13.97	Issue Type +	Ma	Location *	LS
Category	Earthen Levee			GPS Latitude/Longitude	
				Start	End
Item	Vegetation			37.258975 °	37.245727 °
				-120.826389 °	-120.818247 °
DWR ID	DWR_NA0010_01_s_2022_137				
Comment Code					
V1 : Control annual grass and weeds on the levee slopes and easements.					
Inspector Comment

Looking at vegetation on the landside slope. (Spring 2022)

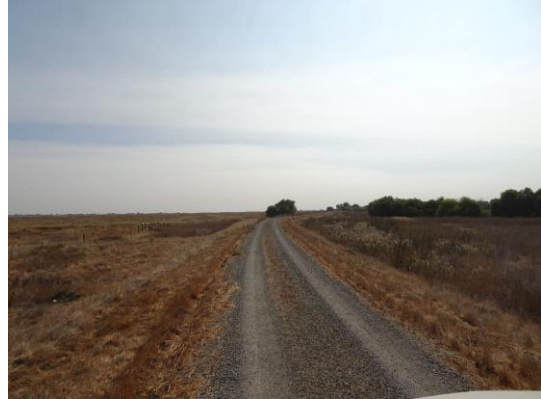
Photo 1 of 3 : UCIP_SP_2022_70690_92843.jpg

Comment Code						
Inspector Comment						
FS_ID:70690 DS_ID:19637 EP_NO: N/A Repair Type: Non-Urgent Crossing Status: Found UCIP Comments: 10/21/2020 Record remains Non-Urgent. DWR DMP has found integrity issues, LOF between 4 and 5. Crossing will be monitored until funding becomes available for rehabilitation. Proper inspection inhibited by dense vegetation. Recommend vegetation removal along pipe alignment. No permit was found authorizing this encroachment. CVFPB will need to review crossing to determine owner. (B. Singh - GEI, O. Magana - DWR UCIP)04/25/2014 Concrete headwall on landward side blocked by debris. Dense vegetation limits the inspector's visibility to identify signs of pipe failure (leaks) along the landward slope. Recommend removing vegetation along pipe alignment to conduct proper inspection of crossing. (O. Magana - DWR UCIP) FIELD_STRUCT_DESC: 24-inch corrugated metal (CM) gravity drainage pipe through the levee, 9.5 feet below the crown. Flap gate on the waterside (WS) end. Brass cap No. 60 bench mark (BM) on the headwall on the landside (LS). [Additional Reference(s): DWR Levee Log, 2002, (HLM 12.95). USACE San Joaquin O&M Manual, Unit No. 601, Part No. 1, (SJR601.1), 1967, Revised 25 May 2011, (HLM 12.94)]. FS Date: 10/21/2020

Overview of levee crown looking upstream towards pipe crossing past curve.

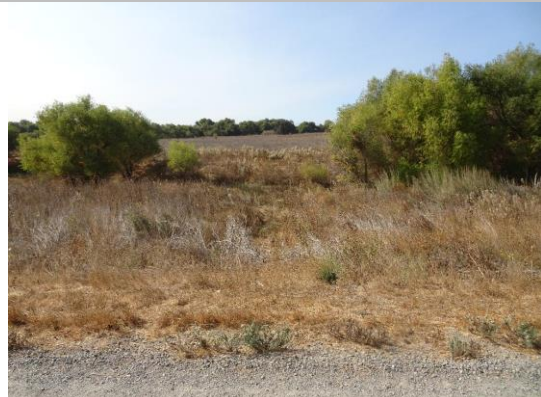
Photo 2 of 3 : UCIP_SP_2022_70690_90965.jpg

WS view: overview of WS

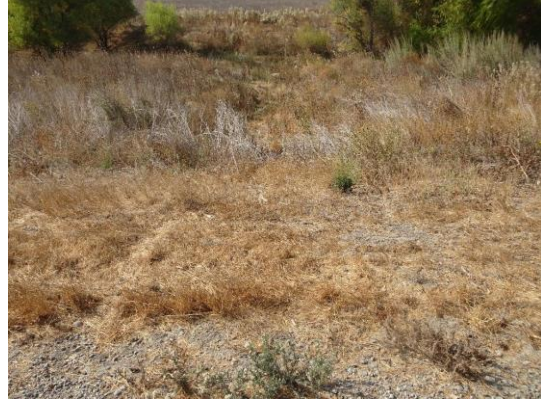
Photo 3 of 3 : UCIP_SP_2022_70690_90966.jpg

WS view: dense vegetation along WS toe. Pipe and flap gate visible on WS toe.

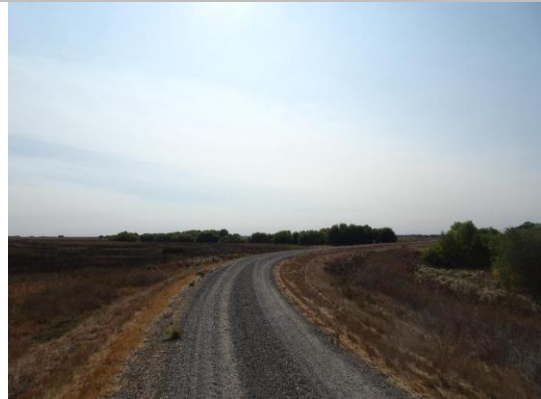
Photo 1 of 3 : UCIP_SP_2022_70691_92844.jpg

FS_ID:70691
DS_ID:19638
EP_NO: N/A
Repair Type: Non-Urgent
Crossing Status: Found
UCIP Comments: 10/21/2020 Record remains Non-Urgent. No permit was found authorizing this encroachment. CVFPB will need to review crossing to determine owner. DWR DMP internal inspection is pending and scheduled for 2021. (B. Singh - GEI, O. Magana - DWR UCIP)04/25/2014 Dense vegetation limits the inspector's visibility to identify signs of pipe failure (leaks) along the landward slope. Concrete headwall blocked by debris located on landward toe. Recommend clearing debris from landward slope and toe. (O. Magana - DWR UCIP) FIELD_STRUCT_DESC: 24-inch corrugated metal (CM) gravity drainage pipe through the levee, 14.2 feet below the crown. Flap gate on the waterside (WS) end. Brass cap No. 60 bench mark (BM) on the headwall on the landside (LS). [Additional Reference(s): DWR Levee Log, 2002, (HLM 13.48). USACE San Joaquin O&M Manual, Unit No. 601, Part No. 1, (SJR601.1), 1967, Revised 25 May 2011, (HLM 13.48)]. FS Date: 10/21/2020

Overview of levee looking upstream towards pipe.

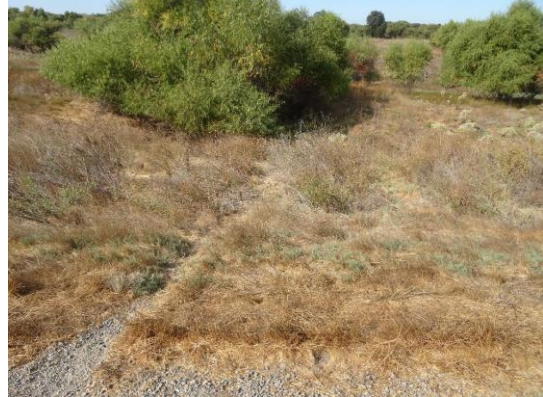
Photo 2 of 3 : UCIP_SP_2022_70691_90967.jpg

WS view: overview of WS

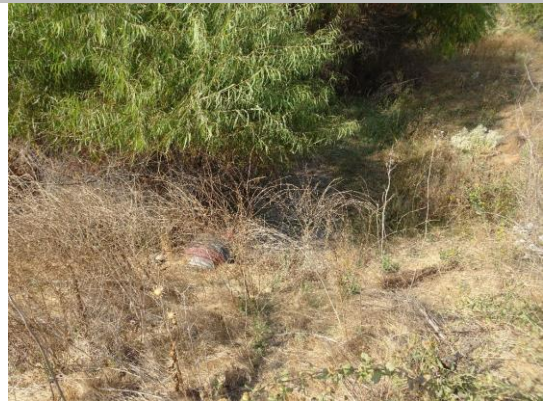
Photo 3 of 3 : UCIP_SP_2022_70691_90969.jpg

WS view: pipe and flapgate visible at WS toe

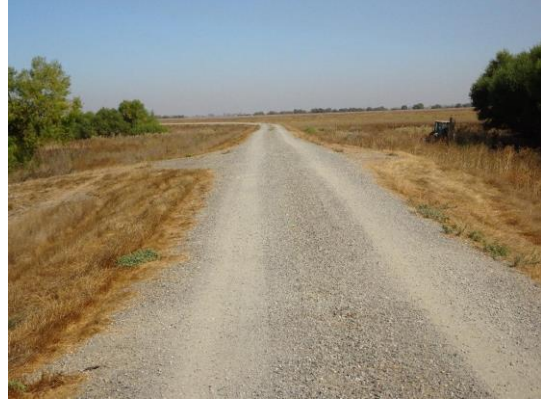
Photo 1 of 3 : UCIP_SP_2022_70692_90971.jpg

Comment Code						
Inspector Comment						
FS_ID:70692 DS_ID:19639 EP_NO: N/A Repair Type: Non-Urgent Crossing Status: Found UCIP Comments: 10/21/2020 Record remains Non-Urgent. No permit was found authorizing this encroachment. CVFPB will need to review crossing to determine owner. DWR DMP internal inspection is pending and scheduled for 2021. (B. Singh - GEI, O. Magana - DWR UCIP)04/25/2014 No access to waterward toe due to fence. Unable to find the concrete headwall and flap gate on waterward side past fence. Also dense vegetation limits the inspector's visibility to identify signs of pipe failure (leaks) along the waterward slope. Recommend removing vegetation along pipe alignment to conduct proper inspection of structure. Also need access past fence on waterward side. (O. Magana - DWR UCIP) FIELD_STRUCT_DESC: 24-inch corrugated metal (CM) gravity drainage pipe through the levee, 14.5 feet below the crown. Flap gate on the waterside (WS) end. Brass cap No. 60 bench mark (BM) on the headwall on the landside (LS). [Additional Reference(s): DWR Levee Log, 2002, (HLM 13.58). USACE San Joaquin O&M Manual, Unit No. 601, Part No. 1, (SJR601.1), 1967, Revised 25 May 2011, (HLM 13.58)]. FS Date: 10/21/2020

Overview of levee crown looking downstream towards crossing.

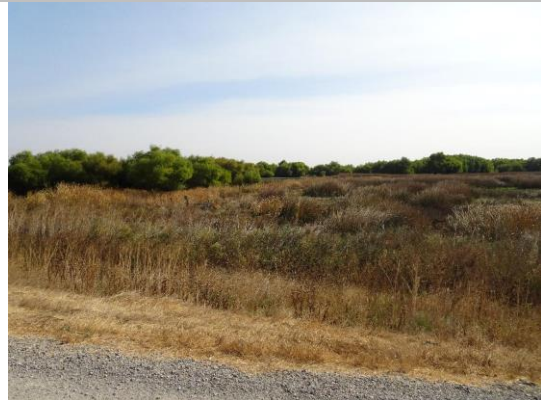
Photo 2 of 3 : UCIP_SP_2022_70692_90973.jpg

LS view: overview of LS. No headwall found through dense vegetation.

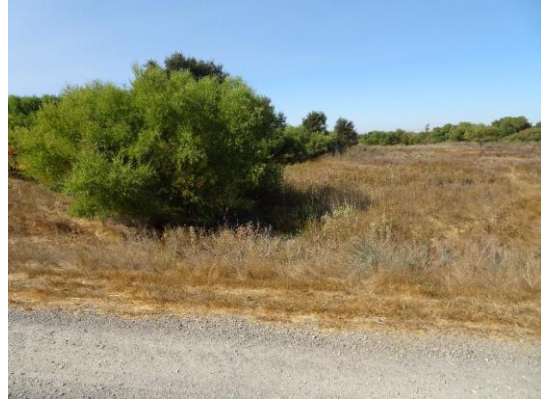
Photo 3 of 3 : UCIP_SP_2022_70692_90972.jpg

WS view: overview of WS.

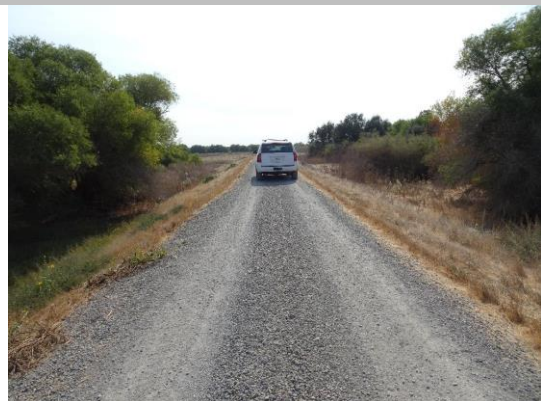
Photo 1 of 3 : UCIP_SP_2022_70694_90986.jpg

FS_ID:70694
DS_ID:19641
EP_NO: N/A
Repair Type: Non-Urgent
Crossing Status: Found
UCIP Comments: 10/21/2020 Record remains Non-Urgent. Dense vegetation at LS and WS toes inhibited proper inspection. No permit was found authorizing this encroachment. CVFPB will need to review crossing to determine owner. DWR DMP has not found internal issues, LOF between 1 and 2. Recommend inspection in 5 years. (B. Singh - GEI, O. Magana - DWR UCIP)04/25/2014 Dense vegetation limits the inspector's visibility to identify signs of pipe failure (leaks) along the slopes. Recommend removing vegetation along pipe alignment to conduct proper inspection of structure. (O. Magana - DWR UCIP) FIELD_STRUCT_DESC: 24-inch corrugated metal (CM) gravity drainage pipe through the levee, 13.0 feet below the crown. Flap gate on the waterside (WS) end. Brass cap No. 60 bench mark (BM) on the headwall on the landside (LS). [Additional Reference(s): DWR Levee Log, 2002, (HLM 14.22). USACE San Joaquin O&M Manual, Unit No. 601, Part No. 1, (SJR601.1), 1967, Revised 25 May 2011, (HLM 14.21)]. FS Date: 10/21/2020

Overview of levee crown looking upstream towards pipe crossing.

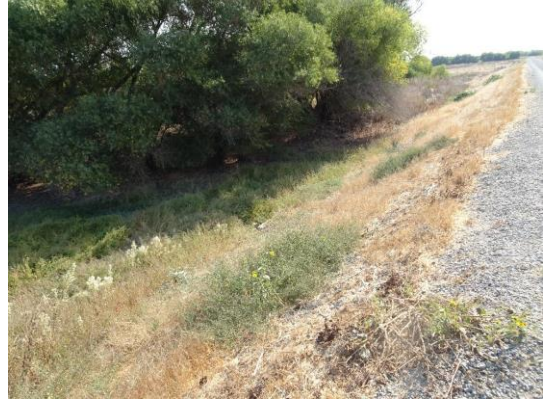
Photo 2 of 3 : UCIP_SP_2022_70694_90988.jpg

LS view: overview of LS

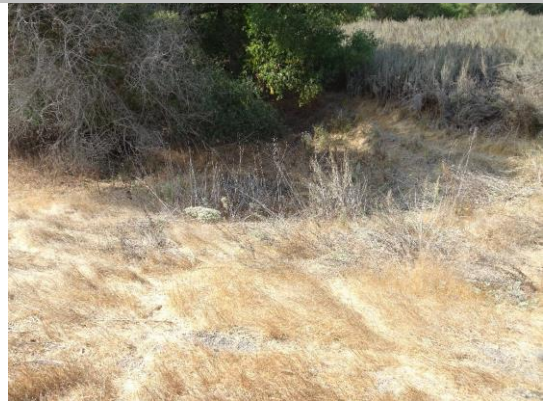
Photo 3 of 3 : UCIP_SP_2022_70694_90990.jpg

WS view: overview of WS

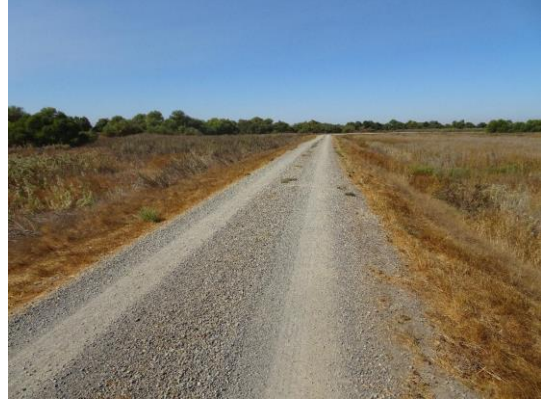
Photo 1 of 3 : UCIP_SP_2022_70695_90992.jpg

Comment Code						
Inspector Comment						
FS_ID:70695 DS_ID:19642 EP_NO: N/A Repair Type: Non-Urgent Crossing Status: Found UCIP Comments: 10/21/2020 Record remains Non-Urgent. Dense vegetation along the pipe alignment prevented proper inspection of the levee and pipe. No permit was found authorizing this encroachment. CVFPB will need to review crossing to determine owner. DWR DMP has not found internal issues, LOF between 1 and 2. Recommend inspection in 5 years. (B. Singh - GEI, O. Magana - DWR UCIP)04/25/2014 Dense vegetation limits the inspector's visibility to identify signs of pipe failure (leaks) along the landward slope and toe. Recommend removing vegetation along pipe alignment to conduct proper inspection of structure. (O. Magana - DWR UCIP) FIELD_STRUCT_DESC: 24-inch corrugated metal (CM) gravity drainage pipe through the levee, 9.7 feet below the crown. Flap gate on the waterside (WS) end. Brass cap No. 60 bench mark (BM) on the headwall on the landside (LS). [Additional Reference(s): DWR Levee Log, 2002, (HLM 14.65). USACE San Joaquin O&M Manual, Unit No. 601, Part No. 1, (SJR601.1), 1967, Revised 25 May 2011, (HLM 14.65)]. FS Date: 10/21/2020

Overview of levee crown looking downstream toward crossing.

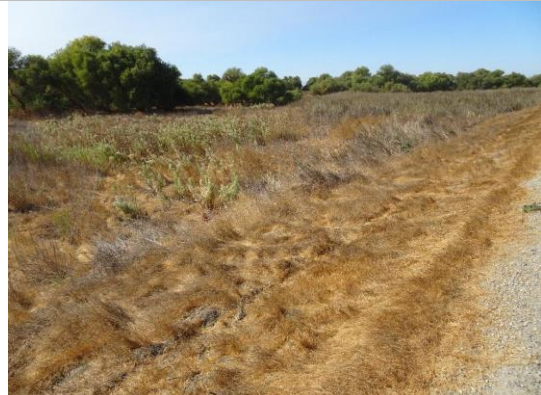
Photo 2 of 3 : UCIP_SP_2022_70695_90993.jpg

WS view: WS slope profile looking downstream

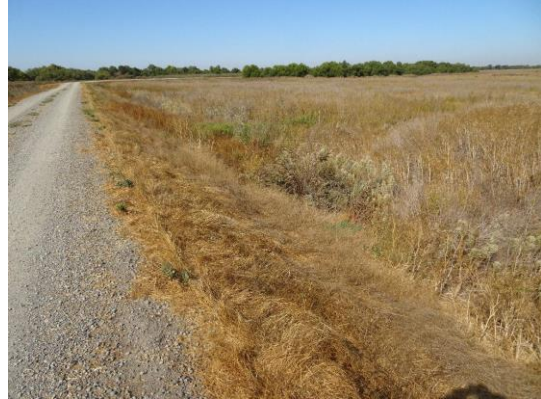
Photo 3 of 3 : UCIP_SP_2022_70695_90994.jpg

LS view: LS slope profile looking downstream

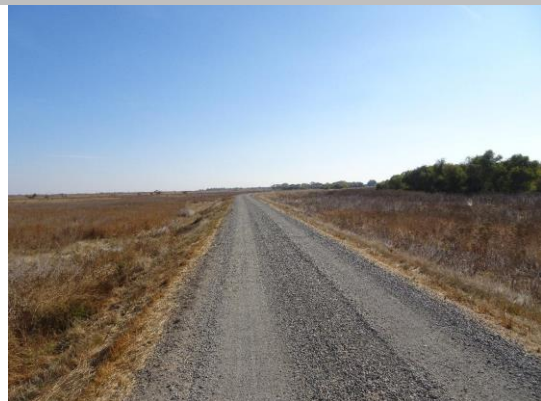
Photo 1 of 3 : UCIP_SP_2022_70696_90792.jpg

FS_ID:70696
DS_ID:19643
EP_NO: N/A
Repair Type: Non-Urgent
Crossing Status: Found
UCIP Comments: 11/16/2020 Record remains Non-Urgent. Dense vegetation on LS toe limited inspection of pipe. Significant burrowing observed on LS and WS slopes. Recommend vegetation removal and rodent mitigation. No permit was found authorizing this encroachment. CVFPB will need to review crossing to determine owner. DWR DMP has not found internal issues, LOF between 1 and 2. Recommend inspection in 5 years. (B. Singh - GEI, O. Magana - DWR UCIP)04/25/2014 Dense vegetation limits the inspector's visibility to identify signs of pipe failure (leaks) along the landward slope. Recommend removing vegetation along pipe alignment to conduct proper inspection of structure. (O. Magana - DWR UCIP)
FIELD_STRUCT_DESC: 24-inch corrugated metal (CM) gravity drainage pipe through the levee, 9.2 feet below the crown. Flap gate on the waterside (WS) end. Brass cap No. 60 bench mark (BM) on the headwall on the landside (LS). [Additional Reference(s): DWR Levee Log, 2002, (HLM 15.31). USACE San Joaquin O&M Manual, Unit No. 601, Part No. 1, (SJR601.1), 1967, Revised 25 May 2011, (HLM 15.29)].

Overview of levee crown, looking US

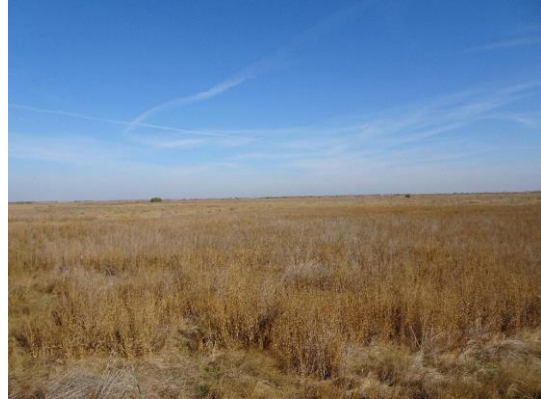
Photo 2 of 3 : UCIP_SP_2022_70696_92869.jpg

LS view: overview of LS.

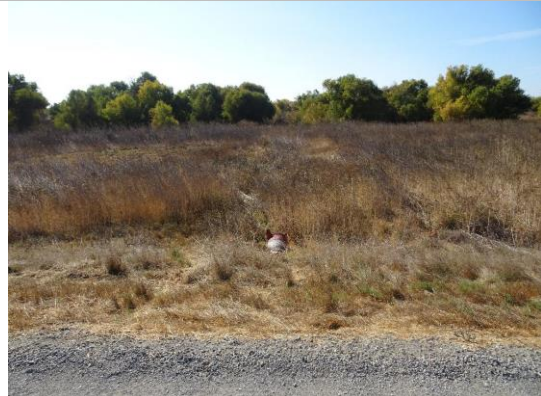
Photo 3 of 3 : UCIP_SP_2022_70696_90793.jpg

WS view: overview of WS. Pipe and flapgate visible on WS toe.

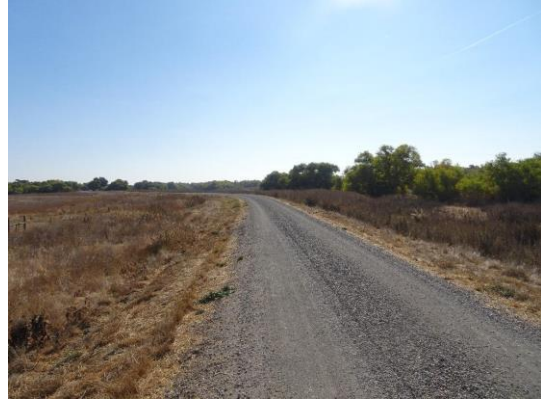
Photo 1 of 3 : UCIP_SP_2022_70697_90797.jpg

Comment Code					
Inspector Comment					
FS_ID:70697 DS_ID:19644 EP_NO: N/A Repair Type: Non-Urgent Crossing Status: Found UCIP Comments: 11/16/2020 Recor remains Non-Urgent. Dense vegetation on LS toe and slope inhibited proper inspection of pipe. No permit was found authorizing this encroachment. CVFPB will need to review crossing to determine owner. DWR DMP has not found internal issues, LOF between 1 and 2. Recommend inspection in 5 years. (O. Magana - DWR UCIP, B. Singh - GEI)04/25/2014 Dense vegetation limits the inspector's visibility to identify signs of pipe failure (leaks) along the waterward and landward slopes. Recommend removing vegetation along pipe alignment to conduct proper inspection of structure. (O. Magana - DWR UCIP) FIELD_STRUCT_DESC: 24-inch corrugated metal (CM) gravity drainage pipe through the levee, 8.5 feet below the crown. Flap gate on the waterside (WS) end. Brass cap No. 60 bench mark (BM) on the headwall on the landside (LS). [Additional Reference(s): DWR Levee Log, 2002, (HLM 15.57). USACE San Joaquin O&M Manual, Unit No. 601, Part No. 1, (SJR601.1), 1967, Revised 25 May 2011, (HLM 15.57)]. FS Date: 11/16/2020

Overview of levee crown, looking US

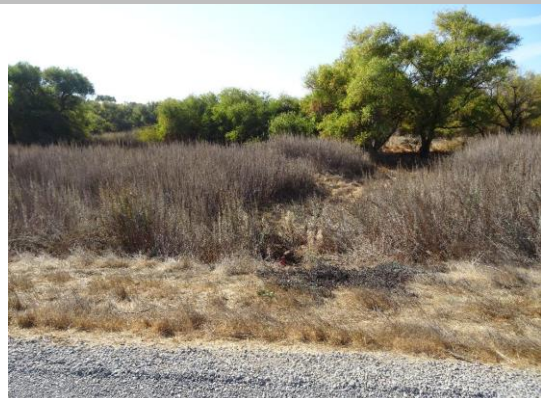
Photo 2 of 3 : UCIP_SP_2022_70697_90798.jpg

WS view: overview of WS. Pipe and flapgate visible at WS toe.

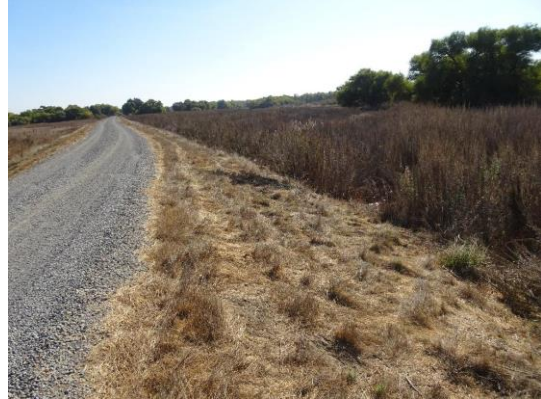
Photo 3 of 3 : UCIP_SP_2022_70697_92963.jpg

WS view: profile of WS slope.

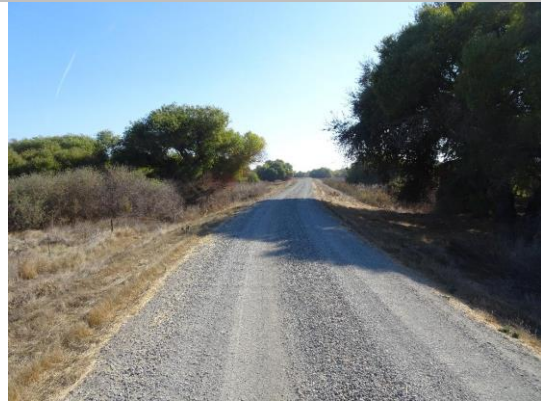
Photo 1 of 3 : UCIP_SP_2022_70698_90803.jpg

Comment Code						
Inspector Comment						
FS_ID:70698 DS_ID:19645 EP_NO: N/A Repair Type: Non-Urgent Crossing Status: Found UCIP Comments: 11/16/2020 Record remains Non-Urgent. Corrosion observed in pipe inlet on the LS toe. Recommend internal inspection of the pipe through the levee to determine extent of damage. Some burrowing activity found on both LS and WS slope. No permit was found authorizing this encroachment. CVFPB will need to review crossing to determine owner. DWR DMP internal inspection is pending and scheduled for 2021. (B. Singh - GEI, O. Magana - DWR UCIP)04/25/2014 Dense vegetation limits the inspector's visibility to identify signs of pipe failure (leaks) along the waterward and landward slope. Recommend removing vegetation along pipe alignment to conduct proper inspection of structure. (O. Magana - DWR UCIP) FIELD_STRUCT_DESC: 24-inch corrugated metal (CM) gravity drainage pipe through the levee, 11.0 feet below the crown. Flap gate on the waterside (WS) end. Brass cap No. 60 bench mark (BM) on the headwall on the landside (LS). [Additional Reference(s): DWR Levee Log, 2002, (HLM 15.82). USACE San Joaquin O&M Manual, Unit No. 601, Part No. 1, (SJR601.1), 1967, Revised 25 May 2011, (HLM 15.81)]. FS Date: 11/16/2020

Overview of levee crown, looking US

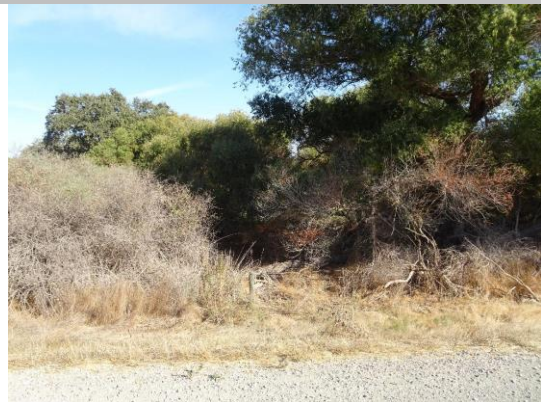
Photo 2 of 3 : UCIP_SP_2022_70698_90804.jpg

LS view: overview of LS

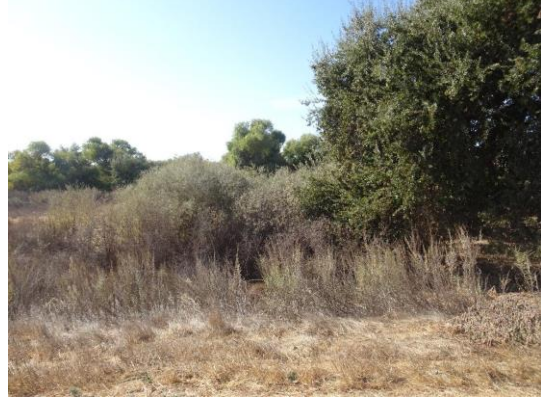
Photo 3 of 3 : UCIP_SP_2022_70698_90805.jpg

WS view: overview of WS

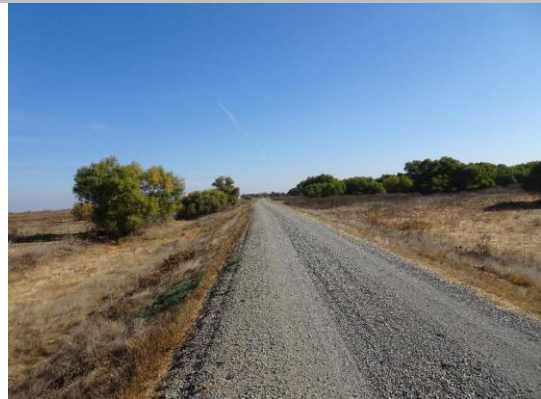
Photo 1 of 3 : UCIP_SP_2022_70699_92966.jpg

FS_ID:70699
DS_ID:19646
EP_NO: N/A
Repair Type: Urgent
Crossing Status: Found
UCIP Comments: 11/16/2020 Record has been updated from Non-Urgent to Urgent. DWR DMP has found integrity issues, LOF between 5 and 6. Crossing will be monitored until funding becomes available to address. Burrowing activity observed on LS and WS slopes. No permit was found authorizing this encroachment. CVFPB will need to review crossing to determine owner. (B. Singh - GEI, O. Magana - DWR UCIP)04/25/2014 Dense vegetation limits the inspector's visibility to identify signs of pipe failure (leaks) along the waterward and landside slopes. Recommend removing vegetation along pipe alignment to conduct proper inspection of structure and appurtenances. (O. Magana - DWR UCIP)
FIELD_STRUCT_DESC: 24-inch corrugated metal (CM) gravity drainage pipe through the levee, 11.3 feet below the crown. Flap gate on the waterside (WS) end. Brass cap No. 50 bench mark (BM) on the headwall on the landside (LS). [Additional Reference(s): DWR Levee Log, 2002, (HLM 16.09). USACE San Joaquin O&M Manual, Unit No. 601, Part No. 1, (SJR601.1), 1967, Revised 25 May 2011, (HLM 16.09)].

Overview of levee looking upstream towards crossing.

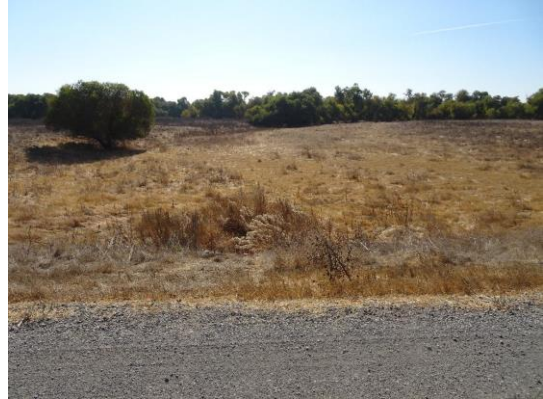
Photo 2 of 3 : UCIP_SP_2022_70699_92967.jpg

WS view: overview of WS.

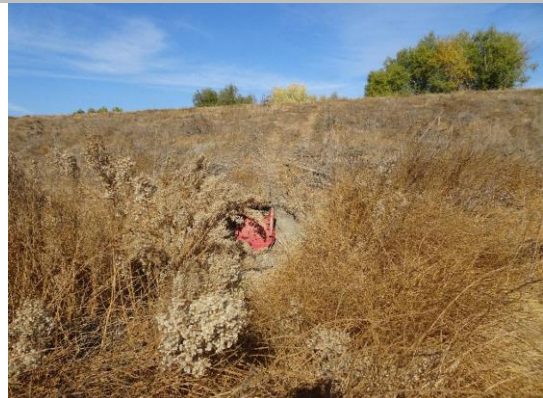
Photo 3 of 3 : UCIP_SP_2022_70699_92965.jpg

WS view: concrete wingwall and pipe with flap gate visible on WS toe.

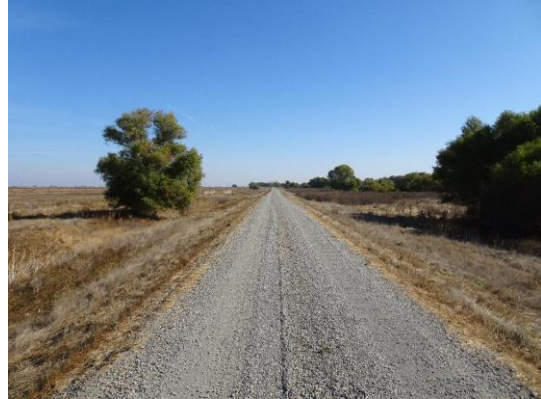
Photo 1 of 3 : UCIP_SP_2022_70700_92979.jpg

FS_ID:70700
DS_ID:19647
EP_NO: N/A
Repair Type: Non-Urgent
Crossing Status: Found
UCIP Comments: 11/16/2020 Record remains Non-Urgent. Pipe and flapgate on WS toe were under water and there is dense vegetation on the LS slope and toe, inhibiting inspection. No permit was found authorizing this encroachment. CVFPB will need to review crossing to determine owner. DWR DMP internal inspection status is pending. Contacted A. Asrate with DMP staff to find out internal inspection results from 2020. (B. Singh - GEI, O. Magana - DWR UCIP)04/25/2014 Dense vegetation limits the inspector's visibility to identify signs of pipe failure (leaks) along the waterward and landward slopes. Recommend removing vegetation along pipe alignment to conduct proper inspection of structure. Unable to find pipe on landward side. (O. Magana - DWR UCIP)
FIELD_STRUCT_DESC: 24-inch corrugated metal (CM) gravity drainage pipe through the levee, 14.7 feet below the crown. Flap gate on the waterside (WS) end. Brass cap No. 50 bench mark (BM) on the headwall on the landside (LS). [Additional Reference(s): DWR Levee Log, 2002, (HLM 16.16). USACE San Joaquin O&M Manual, Unit No. 601, Part No. 1, (SJR601.1), 1967, Revised 25 May 2011, (HLM 16.15)].

Overview of levee crown looking upstream towards pipe crossing.

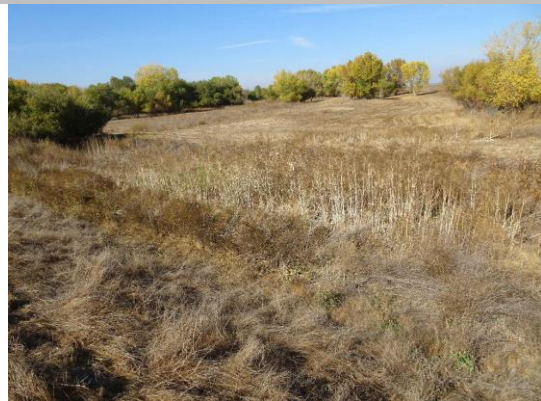
Photo 2 of 3 : UCIP_SP_2022_70700_92980.jpg

LS view: overview of LS.

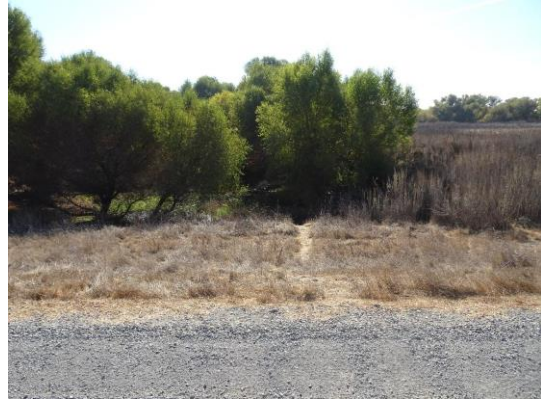
Photo 3 of 3 : UCIP_SP_2022_70700_92978.jpg

WS view: overview of WS.

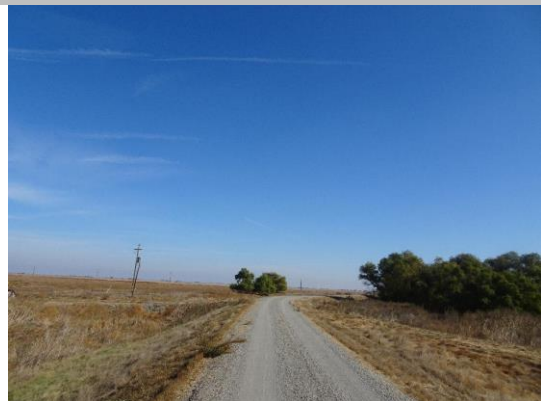
Photo 1 of 3 : UCIP_SP_2022_70703_90820.jpg

FS_ID:70703
 DS_ID:19648
 EP_NO: N/A
 Repair Type: Non-Urgent
 Crossing Status: Found
 UCIP Comments: 11/16/2020 Record remains Non-Urgent. Unable to locate pipe on both LS and WS toes due to dense vegetation. Recommend vegetation removal for proper inspections. DWR DMP internal inspection is pending and scheduled for 2021. No permit was found authorizing this encroachment. CVFPB will need to review crossing to determine owner. (B. Singh - GEI, O. Magana - DWR UCIP)04/25/2014 Dense vegetation limits the inspector's visibility to identify signs of pipe failure (leaks) along the waterward and landward slopes. Recommend removing vegetation along pipe alignment to conduct proper inspection of structure. Unable to find pipe on landward side. (O. Magana - DWR UCIP)
 FIELD_STRUCT_DESC: 24-inch corrugated metal (CM) gravity drainage pipe through the levee, 11.4 feet below the crown. Flap gate on the waterside (WS) end. Brass cap No. 50 bench mark (BM) on the headwall on the landside (LS). [Additional Reference(s): DWR Levee Log, 2002, (HLM 16.73). USACE San Joaquin O&M Manual, Unit No. 601, Part No. 1, (SJR601.1), 1967, Revised 25 May 2011, (HLM 16.72)].

Overview of levee crown, looking US

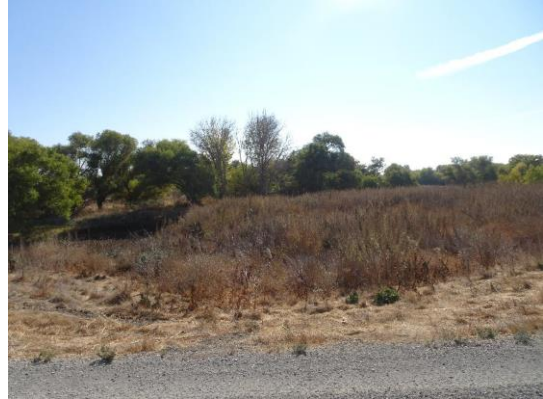
Photo 2 of 3 : UCIP_SP_2022_70703_90821.jpg

WS view: overview of WS. Pipe and flapgate not found; dense vegetation.

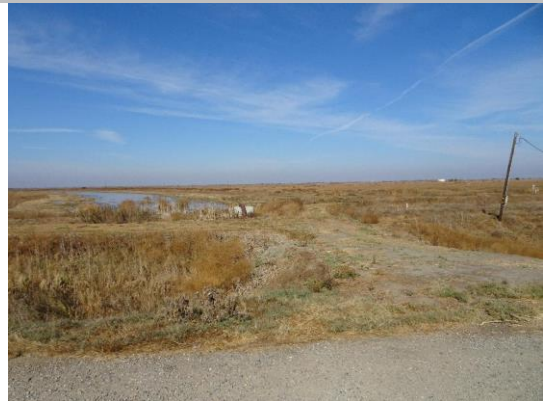
Photo 3 of 3 : UCIP_SP_2022_70703_90824.jpg

LS view: overview of LS.

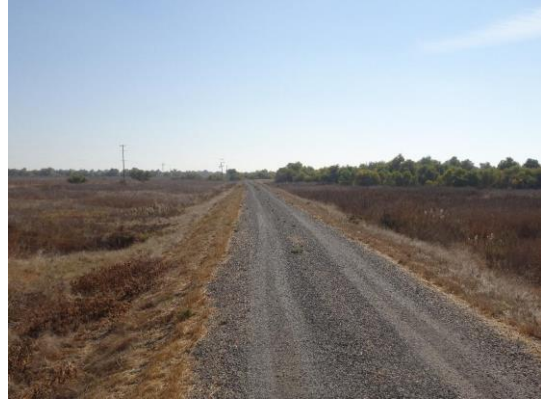
Photo 1 of 3 : UCIP_SP_2022_70704_90825.jpg

Comment Code						
Inspector Comment						
FS_ID:70704 DS_ID:19577 EP_NO: N/A Repair Type: Non-Urgent Crossing Status: Found UCIP Comments: 11/16/2020 Record remains Non-Urgent. No permit was found authorizing this encroachment. CVFPB will need to review crossing to determine owner. DWR DMP has not found internal issues, LOF between 1 and 2. Recommend inspection in 5 years. (B. Singh - GEI, O. Magana - DWR UCIP)04/25/2014 Dense vegetation limits the inspector's visibility to identify signs of pipe failure (leaks) along the waterward and landward slopes. Concrete headwall is buried by dense vegetation. Recommend removing vegetation along pipe alignment to conduct proper inspection of structure. (O. Magana - DWR UCIP) FIELD_STRUCT_DESC: 24-inch corrugated metal (CM) gravity drainage pipe through the levee, 11.5 feet below the crown. Flap gate on the waterside (WS) end. Brass cap No. 50 bench mark (BM) on the headwall on the landside (LS). [Additional Reference(s): DWR Levee Log, 2002, (HLM 17.01). USACE San Joaquin O&M Manual, Unit No. 601, Part No. 1, (SJR601.1), 1967, Revised 25 May 2011, (HLM 17.01)]. FS Date: 11/16/2020

Overview of levee crown, looking US

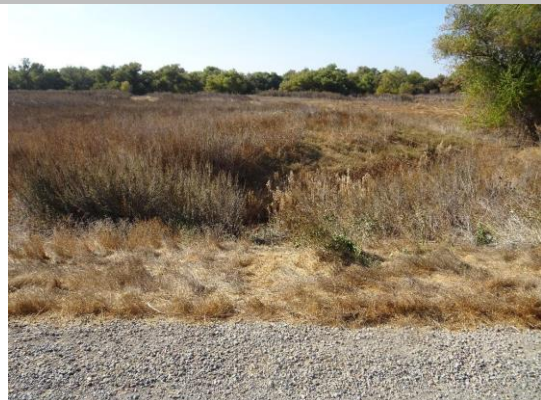
Photo 2 of 3 : UCIP_SP_2022_70704_92993.jpg

WS view: overview of WS.

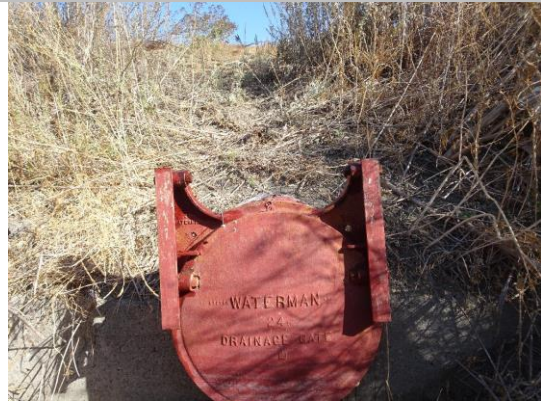
Photo 3 of 3 : UCIP_SP_2022_70704_92991.jpg

WS view: pipe and flap gate visible on WS toe.

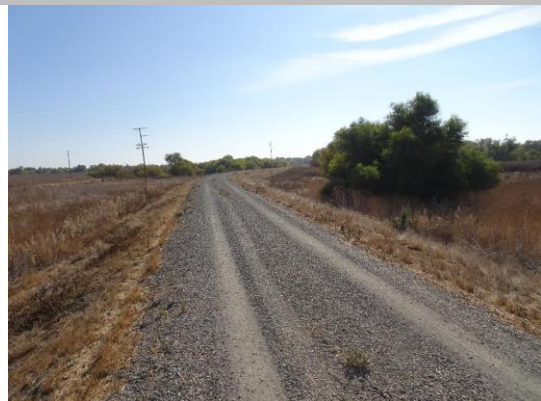
Photo 1 of 3 : UCIP_SP_2022_70705_93002.jpg

FS_ID:70705
DS_ID:19578
EP_NO: N/A
Repair Type: Non-Urgent
Crossing Status: Found
UCIP Comments: 11/16/2020 Record remains Non-Urgent. No permit was found authorizing this encroachment. CVFPB will need to review crossing to determine owner. DWR DMP has not found internal issues, LOF between 1 and 2. Recommend inspection in 5 years. (B. Singh - GEI, O. Magana - DWR UCIP)04/25/2014 Dense vegetation limits the inspector's visibility to identify signs of pipe failure (leaks) along the waterward and landward slopes. Recommend removing vegetation along pipe alignment to conduct proper inspection of structure. Sediment buildup inside pipe visible from landward side. Recommend clearing pipe. (O. Magana - DWR UCIP)
FIELD_STRUCT_DESC: 24-inch corrugated metal (CM) gravity drainage pipe through the levee, 11.5 feet below the crown. Flap gate on the waterside (WS) end. Brass cap No. 50 bench mark (BM) on the headwall on the landside (LS). [Additional Reference(s): DWR Levee Log, 2002, (HLM 17.20). USACE San Joaquin O&M Manual, Unit No. 601, Part No. 1, (SJR601.1), 1967, Revised 25 May 2011, (HLM 17.19)].

Overview of levee crown looking upstream towards pipe crossing.

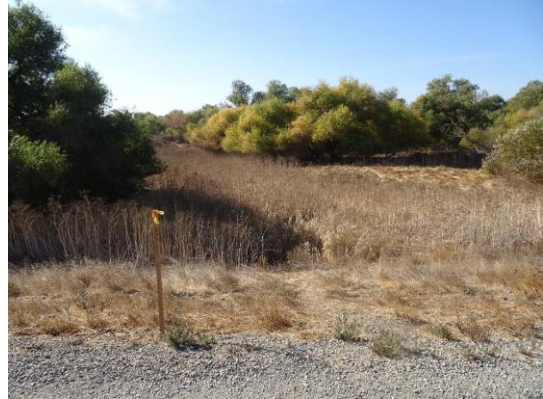
Photo 2 of 3 : UCIP_SP_2022_70705_93003.jpg

WS view: overview of WS.
