**Flood Control Project Maintenance
Levee Inspections**

Maintenance Issue Types Only, Levee Inspection Report By Mile - Spring 2022

Lower San Joaquin Levee District

Waterway	Bank	Unit Miles	Inspection Start/End	Inspector
Unit No. 01 San Joaquin River	Right	22.52	04/05/2022 04/05/2022	Corey Fujitani

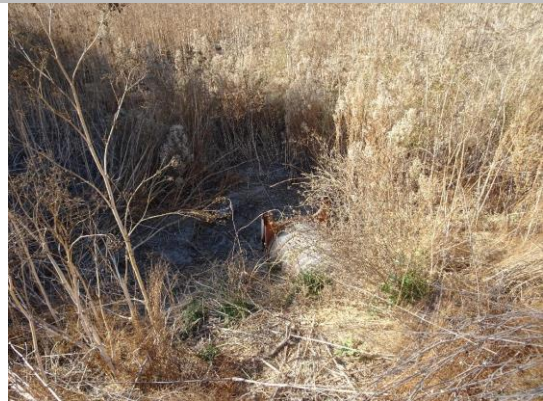
Photo 3 of 3 : UCIP_SP_2022_70705_93000.jpg

WS view: pipe outlet visible on WS toe.

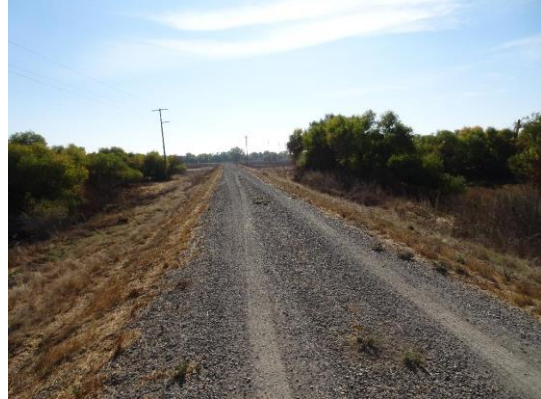
Photo 1 of 3 : UCIP_SP_2022_70706_90834.jpg

FS_ID:70706
DS_ID:19579
EP_NO: N/A
Repair Type: Non-Urgent
Crossing Status: Found
UCIP Comments: 11/16/2020 Record remains Non-Urgent. Debris is blocking flapgate on the WS inlet. No permit was found authorizing this encroachment. CVFPB will need to review crossing to determine owner. DWR DMP internal inspection is pending and scheduled for 2021. (B. Singh - GEI, O. Magana - DWR UCIP)04/25/2014 Dense vegetation limits the inspector's visibility to identify signs of pipe failure (leaks) along the waterward and landward slope. Recommend removing vegetation along pipe alignment to conduct proper inspection of structure. (O. Magana - DWR UCIP)
FIELD_STRUCT_DESC: 24-inch corrugated metal (CM) gravity drainage pipe through the levee, 15.8 feet below the crown. Flap gate on the waterside (WS) end. Brass cap No. 50 bench mark (BM) on the headwall on the landside (LS). [Additional Reference(s): DWR Levee Log, 2002, (HLM 17.27). USACE San Joaquin O&M Manual, Unit No. 601, Part No. 1, (SJR601.1), 1967, Revised 25 May 2011, (HLM 17.26)].

Overview of levee crown looking upstream towards crossing.

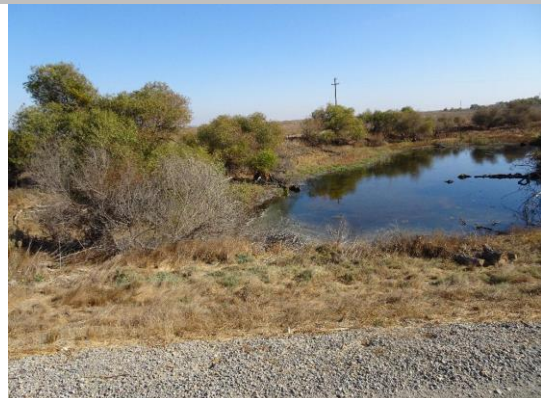
Photo 2 of 3 : UCIP_SP_2022_70706_90835.jpg

LS view: overview of LS

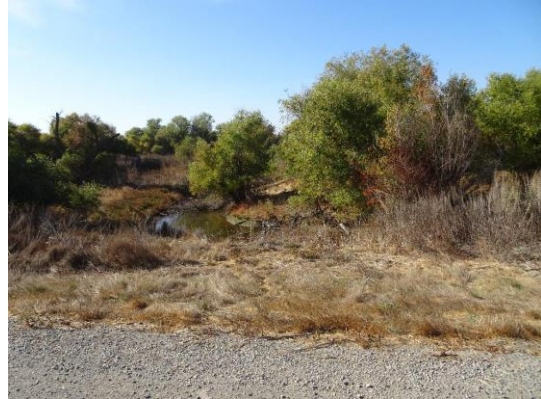
Photo 3 of 3 : UCIP_SP_2022_70706_90836.jpg

WS view: overview of WS, photo 1 of 2.

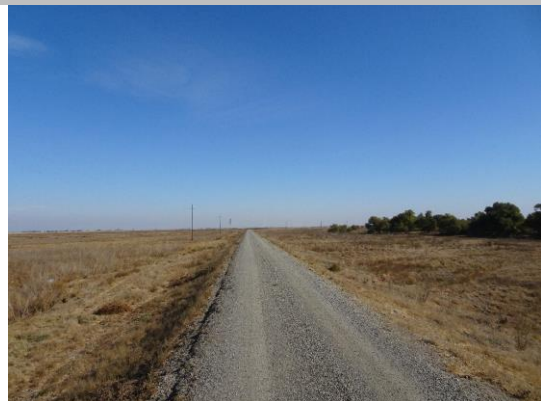
Photo 1 of 3 : UCIP_SP_2022_70707_90843.jpg

FS_ID:70707
 DS_ID:19580
 EP_NO: N/A
 Repair Type: Urgent
 Crossing Status: Found
 UCIP Comments: 11/16/2020 Record has been updated from Non-Urgent to Urgent. Pipe in failed condition on the LS. Potential sink hole located about 1 foot from the LS toe. No permit was found authorizing this encroachment. CVFPB will need to review crossing to determine owner. DWR DMP internal inspection is pending and scheduled for 2021. (B. Singh - GEI, O. Magana - DWR UCIP)04/25/2014 Dense vegetation limits the inspector's visibility to identify signs of pipe failure (leaks) along the landward slope. Recommend removing vegetation along pipe alignment to conduct proper inspection of structure. (O. Magana - DWR UCIP)
 FIELD_STRUCT_DESC: 24-inch corrugated metal (CM) gravity drainage pipe through the levee, 9.5 feet below the crown. Flap gate on the waterside (WS) end. Brass cap No. 50 bench mark (BM) on the headwall on the landside (LS). [Additional Reference(s): DWR Levee Log, 2002, (HLM 17.53). USACE San Joaquin O&M Manual, Unit No. 601, Part No. 1, (SJR601.1), 1967, Revised 25 May 2011, (HLM 17.53)].

Overview of levee crown, looking US

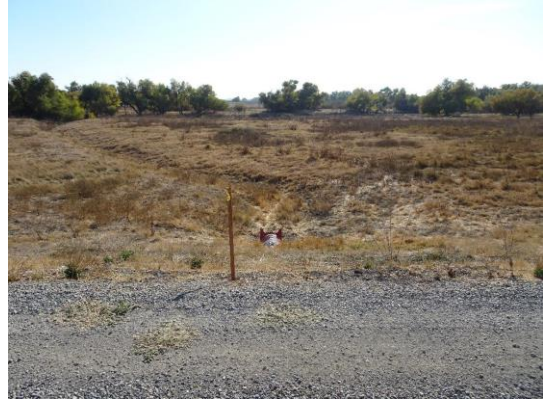
Photo 2 of 3 : UCIP_SP_2022_70707_90844.jpg

WS view: overview of WS. Pipe and flapgate visible on WS toe.

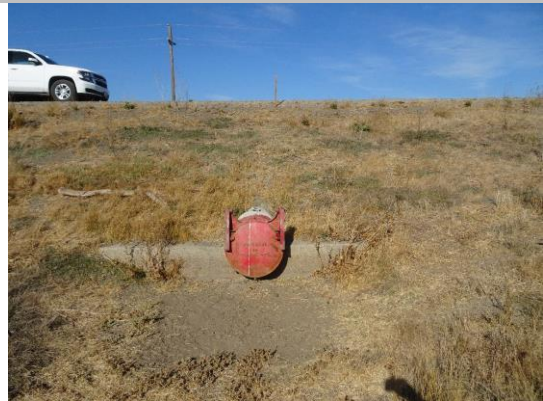
Photo 3 of 3 : UCIP_SP_2022_70707_90842.jpg

WS view: Pipe, headwall, and flapgate at WS toe.

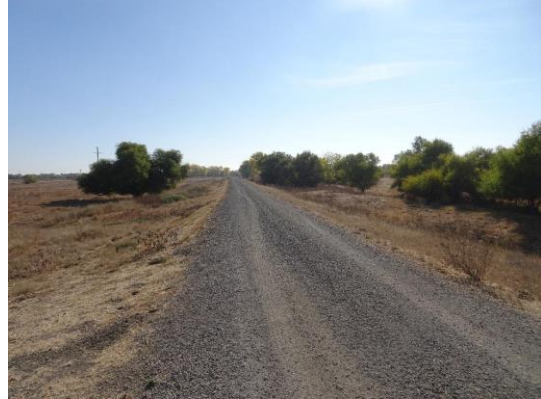
Photo 1 of 3 : UCIP_SP_2022_70708_90849.jpg

Comment Code					
Inspector Comment					
FS_ID:70708 DS_ID:19581 EP_NO: N/A Repair Type: Urgent Crossing Status: Found UCIP Comments: 11/16/2020 Record has been updated from Non-Urgent to Urgent. Considerable damage to the pipe interior is visible from LS toe. DWR DMP has found integrity issues, LOF between 5 and 6. Crossing will be monitored until funding becomes available to address. No permit was found authorizing this encroachment. CVFPB will need to review crossing to determine owner. (B. Singh - GEI, O. Magana - DWR UCIP)04/25/2014 Need to contact owner. Recommend investigating integrity of pipe wall through levee heavy corrosion visible from landward side. (O. Magana - DWR UCIP) FIELD_STRUCT_DESC: 24-inch corrugated metal (CM) gravity drainage pipe through the levee, 11.5 feet below the crown. Flap gate on the waterside (WS) end. Brass cap No. 50 bench mark (BM) on the headwall on the landside (LS). [Additional Reference(s): DWR Levee Log, 2002, (HLM 18.21). USACE San Joaquin O&M Manual, Unit No. 601, Part No. 1, (SJR601.1), 1967, Revised 25 May 2011, (HLM 18.19)]. FS Date: 11/16/2020

Overview of levee crown looking upstream, photo 1 of 2.

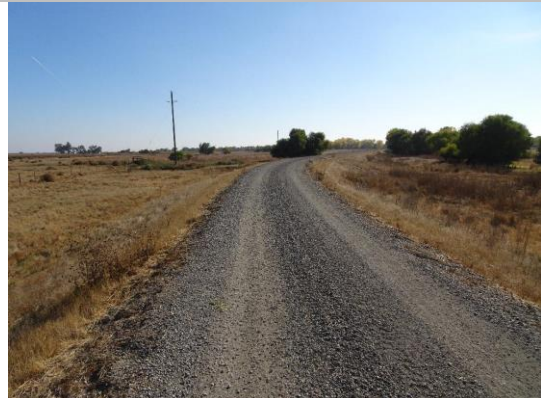
Photo 2 of 3 : UCIP_SP_2022_70708_93033.jpg

Overview of levee crown looking upstream, photo 2 of 2.

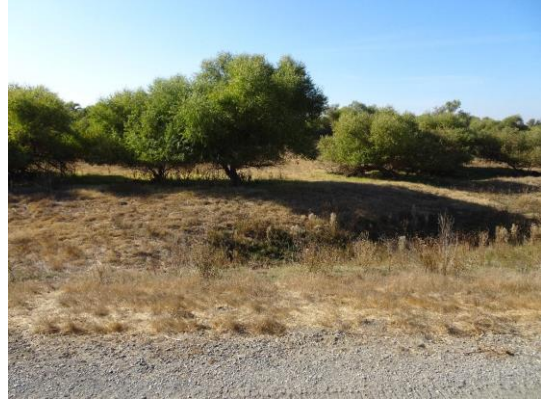
Photo 3 of 3 : UCIP_SP_2022_70708_90852.jpg

WS view: overview of WS.

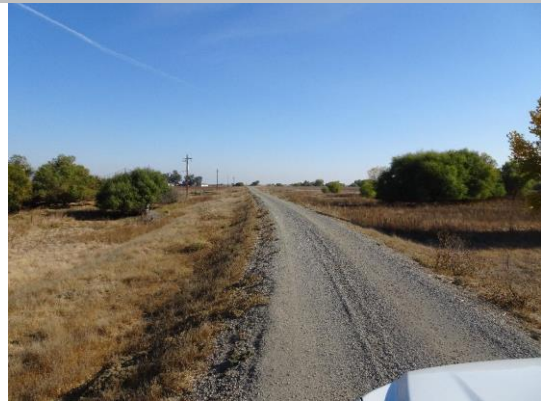
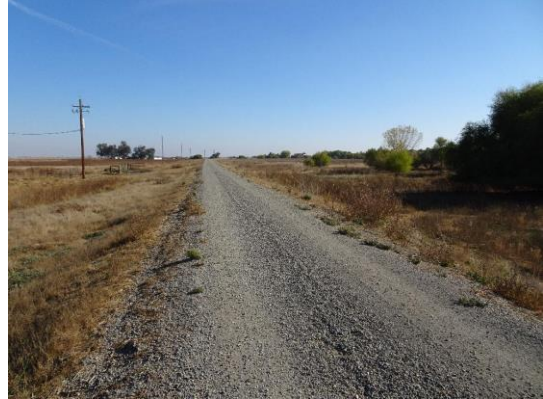
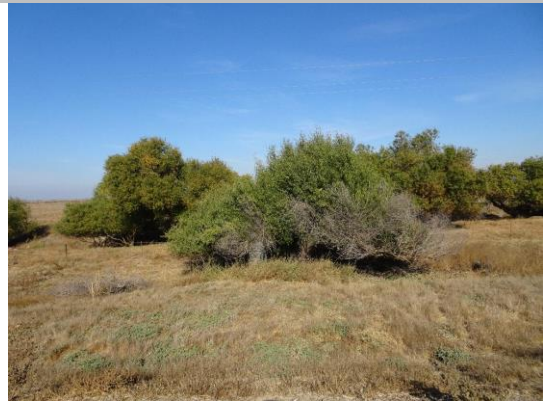
FS_ID:70709
 DS_ID:19582
 EP_NO: N/A
 Repair Type: Urgent
 Crossing Status: Found
 UCIP Comments: 11/16/2020 Record has been updated from No Action Needed to Urgent. DWR DMP has found integrity issues, LOF between 5 and 6. No damage observed on the levee during the field inspection. Crossing will be monitored until funding becomes available to address. No permit was found authorizing this encroachment. CVFPB will need to review crossing to determine owner. (B. Singh - GEI, O. Magana - DWR UCIP)
 FIELD_STRUCT_DESC: 24-inch corrugated metal (CM) gravity drainage pipe through the levee, 9.4 feet below the crown. Flap gate on the waterside (WS) end. Brass cap No. 50 bench mark (BM) on the headwall on the landside (LS). [Additional Reference(s): DWR Levee Log, 2002, (HLM 18.47). USACE San Joaquin O&M Manual, Unit No. 601, Part No. 1, (SJR601.1), 1967, Revised 25 May 2011, (HLM 18.45)].
 FS Date: 11/16/2020

Overview of levee crown looking upstream, photo 1 of 2.

Overview of levee crown looking upstream, photo 2 of 2.

LS view: overview of LS.

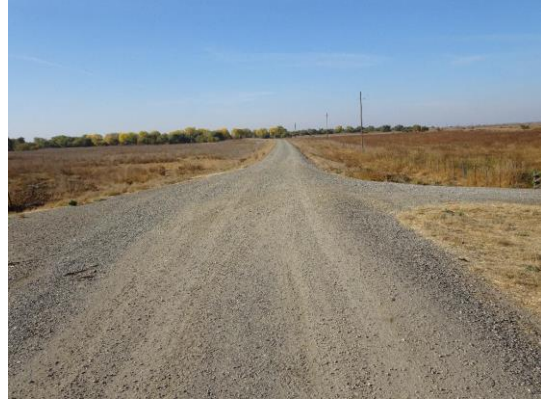
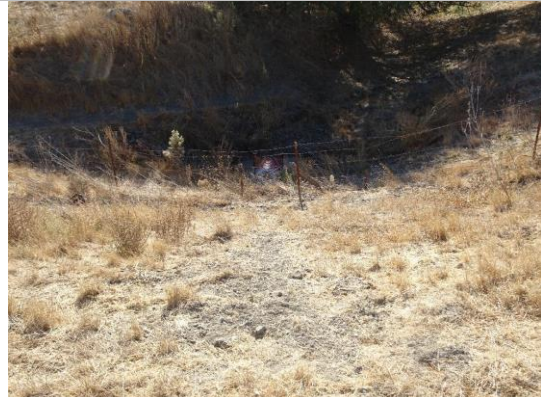
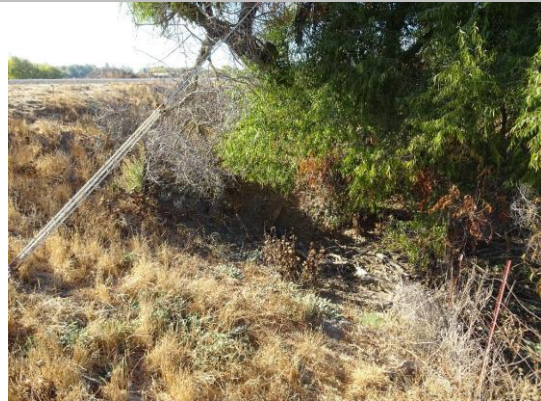
Comment Code						
Inspector Comment						
FS_ID:70711 DS_ID:19593 EP_NO: N/A Repair Type: Non-Urgent Crossing Status: Found UCIP Comments: 11/16/2020 Record remains Non-Urgent. DWR DMP has found integrity issues, LOF between 4 and 5. Crossing will be monitored until funding becomes available for rehabilitation. No permit was found authorizing this encroachment. CVFPB will need to review crossing to determine owner. Fence located on the WS prevented access to the pipe. (B. Singh - GEI, O. Magana - DWR UCIP)04/25/2014 Dense vegetation limits the inspector's visibility to identify signs of pipe failure (leaks) along the landward slope. Recommend removing vegetation along pipe alignment to conduct proper inspection of structure. (O. Magana - DWR UCIP) FIELD_STRUCT_DESC: 24-inch corrugated metal (CM) gravity drainage pipe through the levee, 12.0 feet below the crown. Flap gate on the waterside (WS) end. Brass cap No. 50 bench mark (BM) on the headwall on the landside (LS). [Additional Reference(s): DWR Levee Log, 2002, (HLM 18.80). USACE San Joaquin O&M Manual, Unit No. 601, Part No. 1, (SJR601.1), 1967, Revised 25 May 2011, (HLM 18.79)]. FS Date: 11/16/2020

Overview of levee crown

View waterward

Headwall and pipe at LS toe

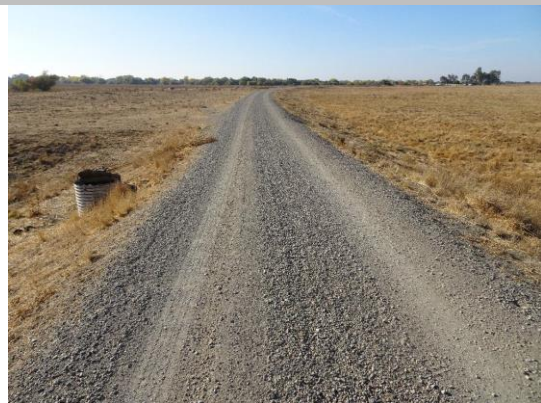
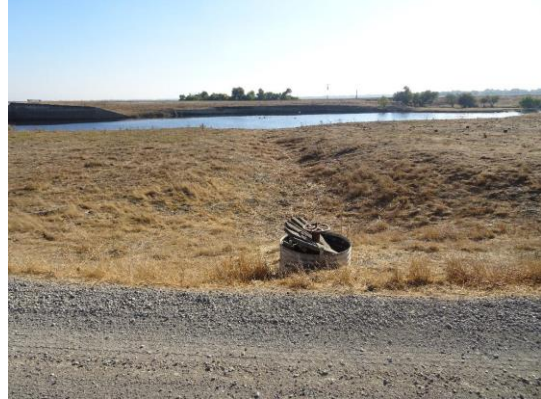
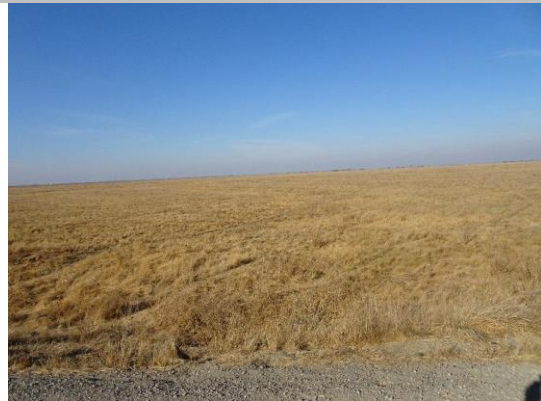
FS_ID:70712
DS_ID:19594
EP_NO: N/A
Repair Type: Non-Urgent
Crossing Status: Found
UCIP Comments: 11/16/2020 Record remains Non-Urgent. Unable to locate pipe on the WS. Pipe appears to be buried on WS. Sediment build-up observed at the LS inlet. Recommend sediment removal and evaluation of pipe's purpose. Pipe is currently non-functional. No permit was found authorizing this encroachment. CVFPB will need to review crossing to determine owner. DWR DMP internal inspection is pending and scheduled for 2021. Recommend adding riser cover on the WS as a safety measure. (B. Singh - GEI, O. Magana - DWR UCIP)04/25/2014 Non-functional crossing--pipe is buried on waterward side. Sediment buildup in pipe visible from landward side. Need to coordinate with owner to determine status. If crossing is no longer in use, owner will need to coordinate with DWR Inspector and CVFPB to properly abandon. (O. Magana - DWR UCIP)

FIELD_STRUCT_DESC: 24-inch corrugated metal (CM) gravity drainage pipe through the levee, 13.0 feet below the crown. Flap gate on the waterside (WS) end. Brass cap No. 40 bench mark (BM) on the headwall on the landside (LS). [Additional Reference(s): DWR Levee Log, 2002, (HLM 19.18). USACE San Joaquin O&M Manual, Unit No. 601, Part No. 1, (SJR601.1), 1967, Revised 25 May 2011, (HLM 19.17)].
FS Date: 11/16/2020

Overview of levee crown

Pipe riser visible on WS slope

View landward

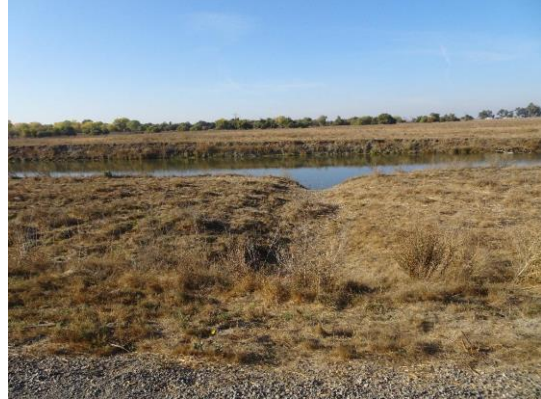
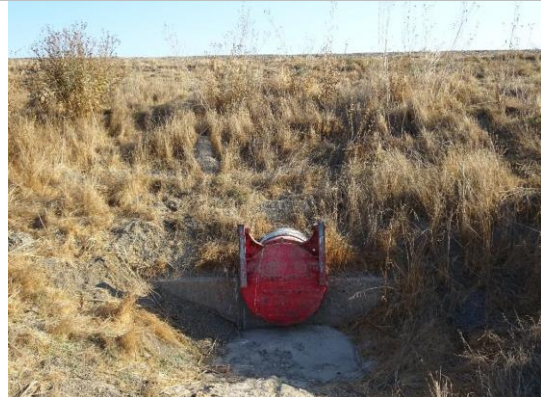
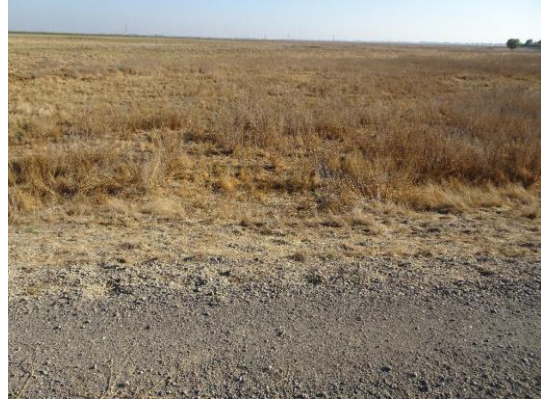
Comment Code						
Inspector Comment						
FS_ID:70716 DS_ID:19596 EP_NO: N/A Repair Type: Non-Urgent Crossing Status: Found UCIP Comments: 11/16/2020 Record remains Non-Urgent. No permit was found authorizing this encroachment. CVFPB will need to review crossing to determine owner. DWR DMP has not found internal issues, LOF between 1 and 2. Recommend inspection in 5 years. (B. Singh - GEI, O. Magana - DWR UCIP)04/25/2014 Dense vegetation limits the inspector's visibility to identify signs of pipe failure (leaks) along the waterward slope. Recommend removing vegetation along pipe alignment to conduct proper inspection of structure. Dense vegetation blocks both waterward and landward headwalls. Sediment buildup in pipe visible from landward side. (O. Magana - DWR UCIP) FIELD_STRUCT_DESC: 24-inch corrugated metal (CM) gravity drainage pipe through the levee, 8.0 feet below the crown. Flap gate on the waterside (WS) end. Brass cap No. 40 bench mark (BM) on the headwall on the landside (LS). [Additional Reference(s): DWR Levee Log, 2002, (HLM 19.54). USACE San Joaquin O&M Manual, Unit No. 601, Part No. 1, (SJR601.1), 1967, Revised 25 May 2011, (HLM 19.54)]. FS Date: 11/16/2020

WS view: overview of WS

WS view: concrete headwall, flap gate, and WS slope visible on WS.

LS view: overview of LS

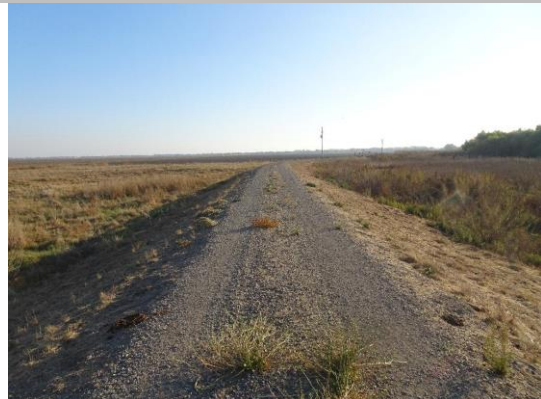
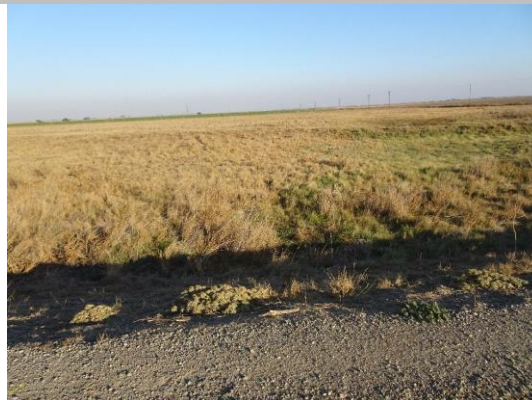
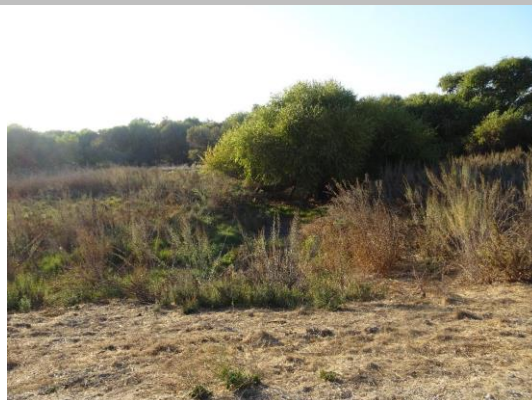
FS_ID:70718
 DS_ID:19598
 EP_NO: N/A
 Repair Type: Non-Urgent
 Crossing Status: Found
 UCIP Comments: 11/16/2020 Record remains Non-Urgent. Limited access due to steep slopes. No permit was found authorizing this encroachment. CVFPB will need to review crossing to determine owner. DWR DMP internal inspection is pending and scheduled for 2021. (B. Singh - GEI, O. Magana - DWR UCIP)04/25/2014 Recommend removing vegetation and sediment buildup from both waterward and landward concrete headwalls. (O. Magana - DWR UCIP)
 FIELD_STRUCT_DESC: 24-inch corrugated metal (CM) gravity drainage pipe through the levee, 8.5 feet below the crown. Flap gate on the waterside (WS) end. Brass cap No. 40 bench mark (BM) on the headwall on the landside (LS). [Additional Reference(s): DWR Levee Log, 2002, (HLM 20.19). USACE San Joaquin O&M Manual, Unit No. 601, Part No. 1, (SJR601.1), 1967, Revised 25 May 2011, (HLM 20.18)].

Overview of levee crown looking upstream

LS view: overview of LS.

WS view: overview of WS.

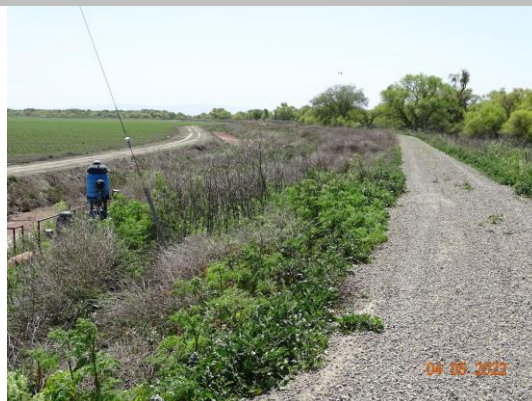
LM Start	20.26	Rating **	U	Issue No.	141
LM End	21.63	Issue Type +	Ma	Location *	LS
Category	Earthen Levee			GPS Latitude/Longitude	
				Start	End
Item	Vegetation			37.193641 °	37.177626 °
				-120.760183 °	-120.757951 °
DWR ID	DWR_NA0010_01_s_2022_141				
Comment Code					
V1 : Control annual grass and weeds on the levee slopes and easements.					
Inspector Comment

View of vegetation on the landside slope looking upstream. (Spring 2022)

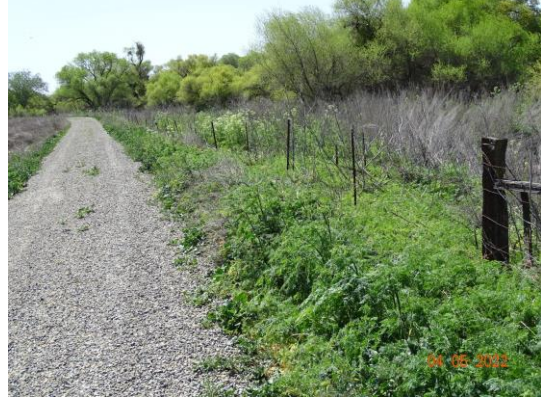
LM Start	20.26	Rating **	M	Issue No.	142
LM End	22.50	Issue Type +	Ma	Location *	WS
Category	Earthen Levee			GPS Latitude/Longitude	
				Start	End
Item	Vegetation			37.193632 °	37.167104 °
				-120.760194 °	-120.750272 °
DWR ID	DWR_NA0010_01_s_2022_142				
Comment Code					
V1 : Control annual grass and weeds on the levee slopes and easements.					
Inspector Comment

View of vegetation growing on the waterside slope. (Spring 2022)

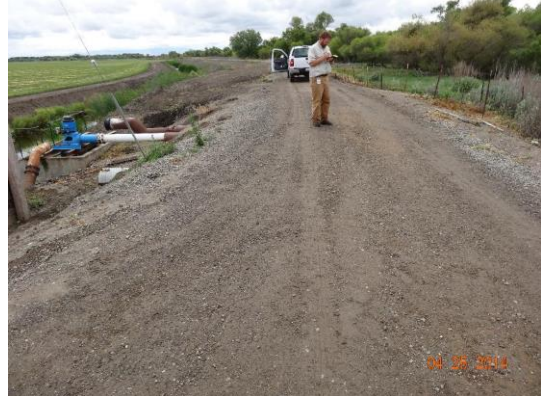
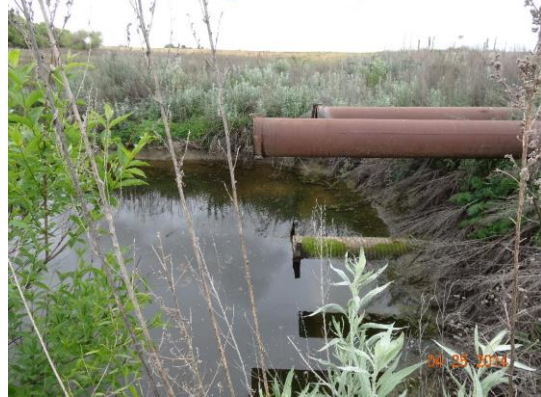
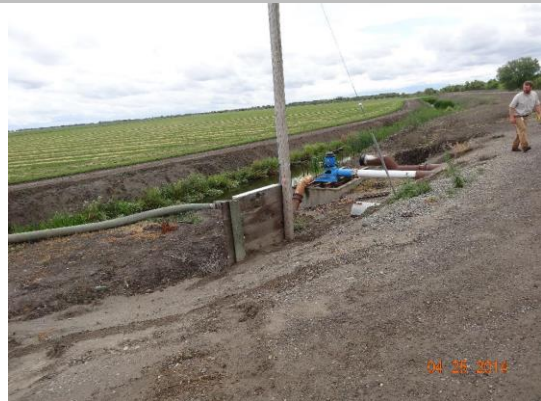
Comment Code						
Inspector Comment						
FS_ID:70721 DS_ID:19600 EP_NO: N/A Repair Type: Non-Urgent Crossing Status: Found UCIP Comments: 11/16/2020 Record remains Non-Urgent. Dense vegetation and fence on the WS prevented proper inspection of pipe. No permit has been found authorizing this pipe. CVFPB will need to review crossing to determine owner. (O. Magana - DWR UCIP)04/25/2014 Crossing partially submersed--no signs of failure of pipe present along pipe alignment. Recommend contacting owner to determine status of crossing and condition. (O. Magana - DWR UCIP) FIELD_STRUCT_DESC: 36-inch corrugated metal (CM) gravity drainage pipe through the levee, 10.5 feet below the crown. Flap gate on the waterside (WS) end. Brass cap No. 40 bench mark (BM) on the headwall on the landside (LS). [Additional Reference(s): DWR Levee Log, 2002, (HLM 20.28). USACE San Joaquin O&M Manual, Unit No. 601, Part No. 1, (SJR601.1), 1967, Revised 25 May 2011, (HLM 20.27)]. FS Date: 11/6/2020

Overview of levee crown at crossing--multiple crossings at this location.

Multiple crossings visible on waterward side--36 inch CMP is submersed in water.

View of landward side.

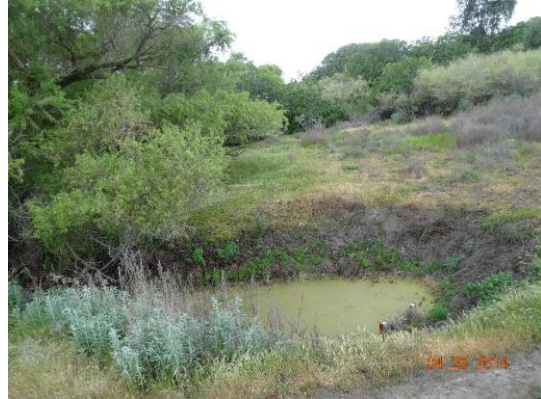
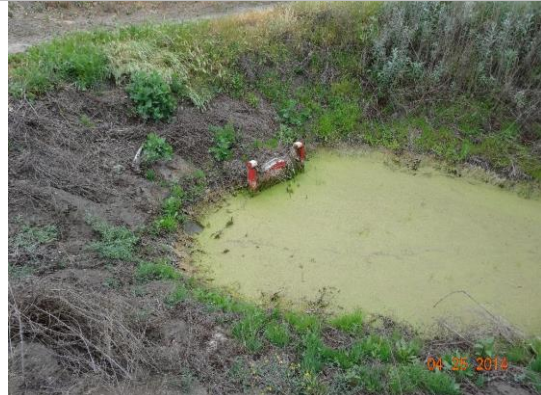
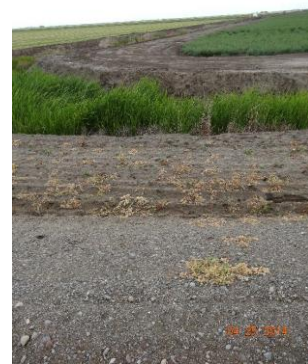
Comment Code						
Inspector Comment						
FS_ID:70727 DS_ID:19603 EP_NO: N/A Repair Type: Non-Urgent Crossing Status: Found UCIP Comments: 05/06/2021 Record remains Non-Urgent. This crossing appears to be non-functional based on the 2014 UCIP inspection. No field inspection has been completed by UCIP. DWR DMP internal inspection is pending and scheduled for 2021. Recommend having UCIP inspector or Levee inspector take current photos of the site. (O. Magana - DWR UCIP)04/25/2014 Crossing is non-functional--crossing buried on landward side. Need to contact owner to determine status of crossing. If crossing is no longer used need to coordinate with CVFPB for proper abandonment. (O. Magana - DWR UCIP) FIELD_STRUCT_DESC: 36-inch corrugated metal (CM) gravity drainage pipe through the levee, 11.5 feet below the crown. Flap gate on the waterside (WS) end. Brass cap No. 40 bench mark (BM) on the headwall on the landside (LS). [Additional Reference(s): DWR Levee Log, 2002, (HLM 21.41). USACE San Joaquin O&M Manual, Unit No. 601, Part No. 1, (SJR601.1), 1967, Revised 25 May 2011, (HLM 21.40)]. FS Date: 5/16/2021

View of waterward side.

Flap gate half way submersed located on waterward side.

View of landward side.

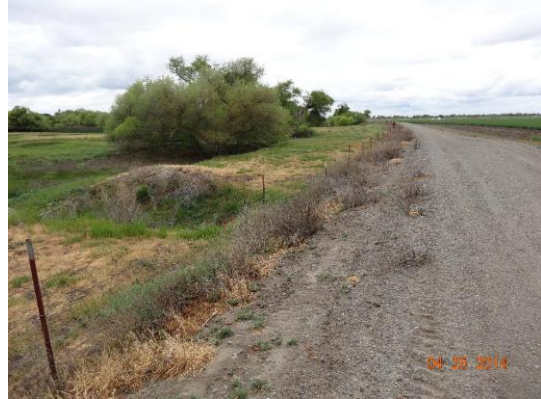
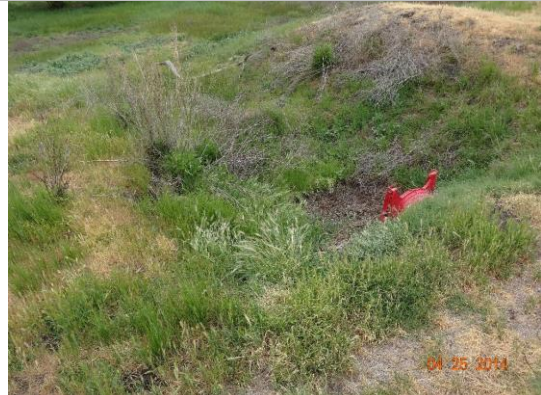
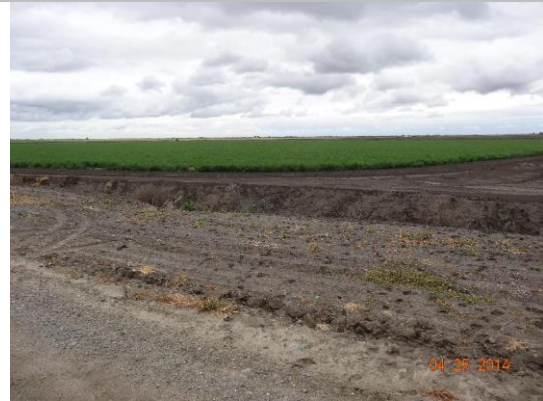
Comment Code						
Inspector Comment						
FS_ID:70728 DS_ID:19604 EP_NO: N/A Repair Type: Non-Urgent Crossing Status: Found UCIP Comments: 05/06/2021 Record remains Non-Urgent. This crossing appears to be non-functional based on the 2014 UCIP inspection. No field inspection has been completed by UCIP. DWR DMP internal inspection is pending and scheduled for 2021. Recommend having UCIP inspector or Levee inspector take current photos of the site. (O. Magana - DWR UCIP)04/25/2014 Non-functional crossing-landward side is buried. Need to contact owner to determine status of crossing. If crossing is no longer used need to coordinate with CVFPB for proper abandonment. (O. Magana - DWR UCIP) FIELD_STRUCT_DESC: 24-inch corrugated metal (CM) gravity drainage pipe through the levee, 9.0 feet below the crown. Flap gate on the waterside (WS) end. Brass cap No. 40 bench mark (BM) on the headwall on the landside (LS). [Additional Reference(s): DWR Levee Log, 2002, (HLM 21.78). USACE San Joaquin O&M Manual, Unit No. 601, Part No. 1, (SJR601.1), 1967, Revised 25 May 2011, (HLM 21.76)]. FS Date: 5/6/2021 9:50:00 AM

View of waterward side.

Flap gate visible on waterward side.

View of landward side.

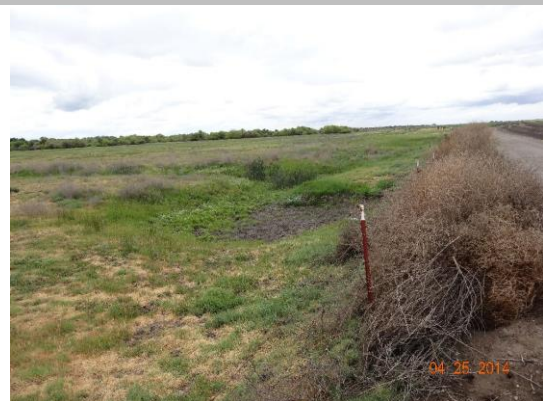
FS_ID:70729
DS_ID:19605
EP_NO: N/A
Repair Type: Non-Urgent
Crossing Status: Found
UCIP Comments: 05/06/2021 Record remains Non-Urgent. This crossing appears to be non-functional based on the 2014 UCIP inspection. No field inspection has been completed by UCIP. DWR DMP internal inspection is pending and scheduled for 2021. Recommend having UCIP inspector or Levee inspector take current photos of the site. (O. Magana - DWR UCIP)04/25/2014 Non-functional crossing--landward side is buried. Need to contact owner to determine status. If crossing is no longer used need to coordinate with CVFPB for proper abandonment. (O. Magana - DWR UCIP)
FIELD_STRUCT_DESC: 24-inch corrugated metal (CM) gravity drainage pipe through the levee, 9.0 feet below the crown. Flap gate on the waterside (WS) end. Wooden headboards on the landside (LS) end. Brass cap No. 31 bench mark (BM) on the headwall on the LS.
[Additional Reference(s): DWR Levee Log, 2002, (HLM 22.13). USACE San Joaquin O&M Manual, Unit No. 601, Part No. 1, (SJR601.1), 1967, Revised 25 May 2011, (HLM 22.13)].

View of waterward side.

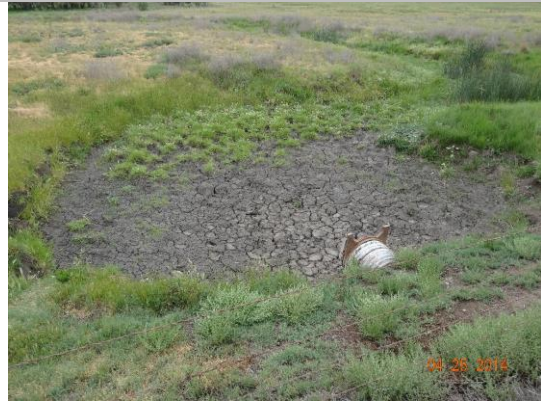
Photo 2 of 3 : UCIP_SP_2022_70729_65707.jpg

Flap gate visible on waterward side.

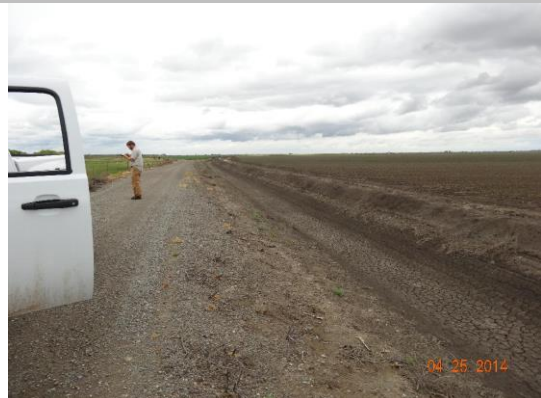
Photo 3 of 3 : UCIP_SP_2022_70729_65708.jpg

View of landward side.

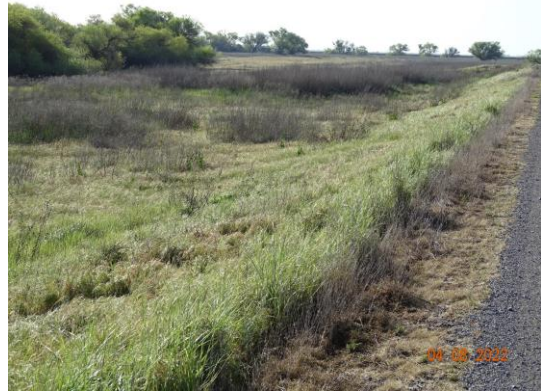
Photo 1 of 1 : SP_2022_NA0010_119_25_20220412_00070.jpg

LM Start	0.06	Rating **	M	Issue No.	25
LM End	6.81	Issue Type +	Ma	Location *	WS
Category	Earthen Levee			GPS Latitude/Longitude	
				Start	End
Item	Vegetation			37.295683 °	37.243355 °
				-120.880082 °	-120.822434 °
DWR ID	DWR_NA0010_02A_s_2022_25				
Comment Code					
V1 : Control annual grass and weeds on the levee slopes and easements.					
Inspector Comment

Looking upstream along the waterside slope. (Spring 2022)

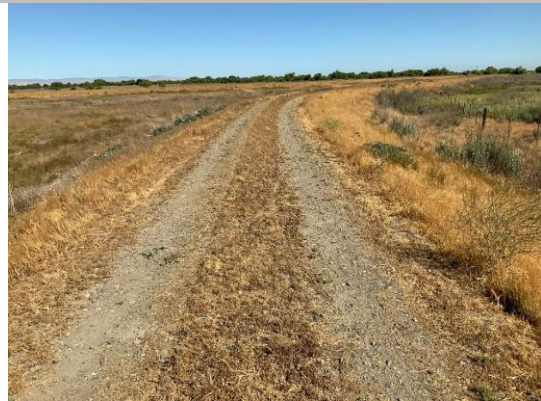
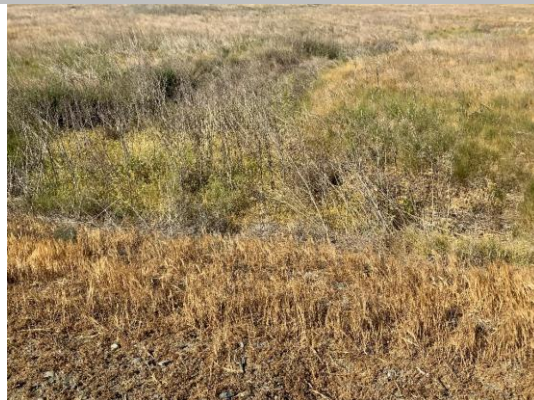
Levee crown looking downstream.

LS view: Toe from crown.

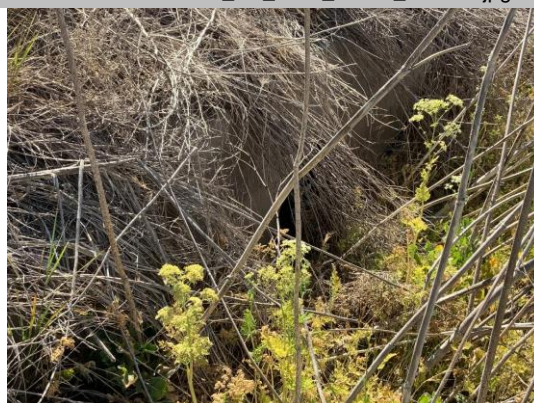
Photo 3 of 3 : UCIP_SP_2022_70933_100059.jpg

Comment Code						
Inspector Comment						
FS_ID:70933 DS_ID:19652 EP_NO: N/A Repair Type: Non-Urgent Crossing Status: Found UCIP Comments: 06/8/2021 Record remains Non-Urgent. There is dense vegetation around the LS pipe inlet, recommend removing to better inspect pipe. No permit was found authorizing this encroachment. CVFPB will need to review crossing to determine owner. The UCIP inspection was completed with GEI staff, P. Espinoza. (H. Dunn ? GEI) 05/01/2014 Dense vegetation limits the inspector's visibility to identify signs of pipe failure (leaks) along the slope. Recommend removing vegetation along pipe alignment to conduct proper inspection of structure. (O. Magana - DWR UCIP) FIELD_STRUCT_DESC: 24-inch corrugated metal gravity drainage pipe (CMP) through the levee, 11.0 feet below the crown. Flap gate on the waterside (WS) end. Brass cap No. 139 bench mark (BM) on the headwall on the landside (LS). [Additional Reference(s): DWR Levee Log, 2002, (HLM 0.24). USACE San Joaquin O&M Manual, Unit No. 601, Part No. 1, 1967, Amended in 1978, Revised 20 June 1985, (HLM 0.24)]. FS Date: 6/8/2021

LS view: Close up of pipe inlet at toe, vegetation covering opening.

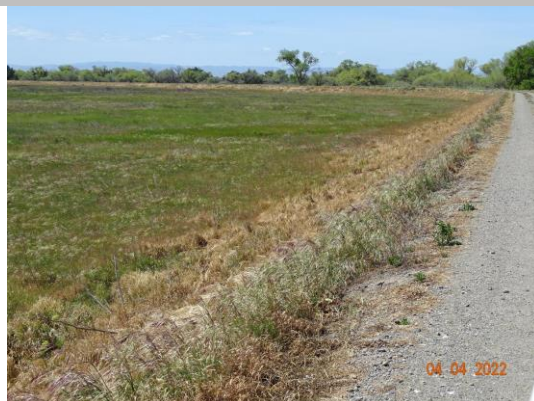
Photo 1 of 1 : SP_2022_NA0010_119_24_20220412_00071.jpg

LM Start	0.63	Rating **	M	Issue No.	24
LM End	4.11	Issue Type +	Ma	Location *	LS
Category	Earthen Levee			GPS Latitude/Longitude	
				Start	End
Item	Vegetation			37.288481 °	37.278105 °
				-120.875171 °	-120.832506 °
DWR ID	DWR_NA0010_02A_s_2022_24				
Comment Code					
V1 : Control annual grass and weeds on the levee slopes and easements.					
Inspector Comment

View of the landside slope looking downstream. (Spring 2022)

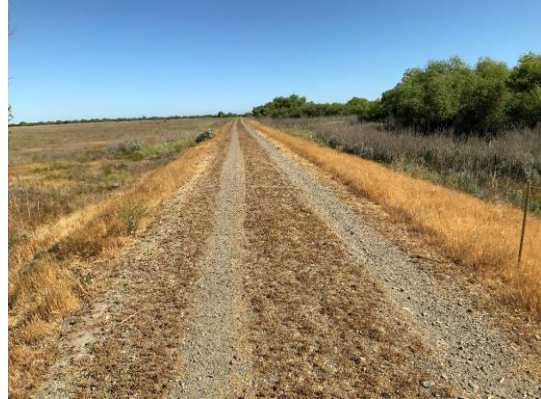
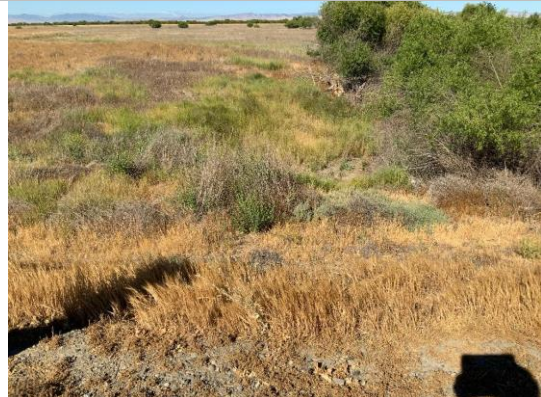
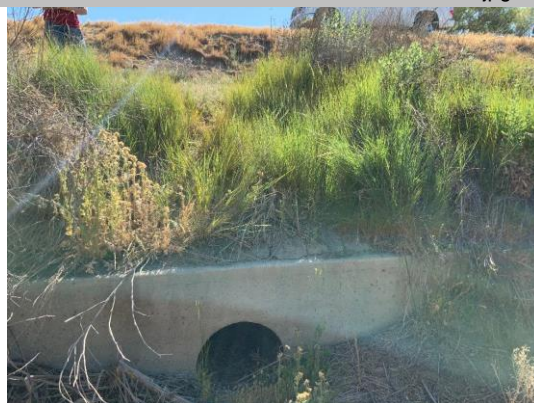
Comment Code						
Inspector Comment						
FS_ID:70934 DS_ID:19653 EP_NO: N/A Repair Type: Non-Urgent Crossing Status: Found UCIP Comments: 06/8/2021 The record remains Non-Urgent. Some vegetation debris inside LS pipe inlet, recommend removal. No permit was found authorizing this encroachment. CVFPB will need to review crossing to determine owner. The UCIP inspection was completed with GEI staff, P. Espinoza. (H. Dunn ? GEI) 05/01/2014 Dense vegetation limits the inspector's visibility to identify signs of pipe failure (leaks) along the slope. Recommend removing vegetation along pipe alignment to conduct proper inspection of structure. (O. Magana - DWR UCIP) FIELD_STRUCT_DESC: 24-inch corrugated metal gravity drainage pipe (CMP) through the levee, 14.8 feet below the crown. Flap gate on the waterside (WS) end. Brass cap No. 138 bench mark (BM) on the headwall on the landside (LS). [Additional Reference(s): DWR Levee Log, 2002, (HLM 0.69). USACE San Joaquin O&M Manual, Unit No. 601, Part No. 1, 1967, Amended in 1978, Revised 20 June 1985, (HLM 0.67)]. FS Date: 6/8/2021

Levee crown looking downstream.

LS view: Toe from crown.

LS view: Slope, headwall, and inlet at toe.

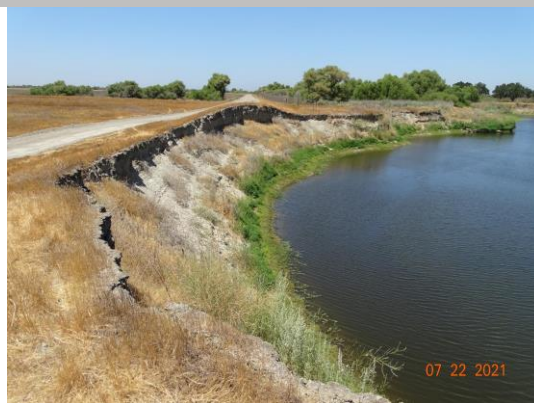
Photo 1 of 3 : SP_2022_NA0010_119_1_20220308_00001.jpg

LM Start	0.68	Rating **	U	Issue No.	1
LM End	0.74	Issue Type +	Ma	Location *	WS
Category	Supplemental			GPS Latitude/Longitude	
				Start	End
Item	DWR Erosion Survey			37.287517 °	37.287517 °
				-120.874583 °	-120.874583 °
DWR ID	NA0010U02ARM129.22				
Comment Code					
Inspector Comment					
Site ID: NA0010U02ARM129.22					
07/22/2021: No significant changes were observed since the previous inspection.					
08/20/2020: This site was discovered during the DWR Spring 2012 Levee Inspections. A 250-ft long levee section has completely eroded away and no longer provides adequate flood protection. Note: Unit 2A is in the process of being turned over to State Parks.

7/22/2021: View of the erosion and missing levee segment looking downstream.

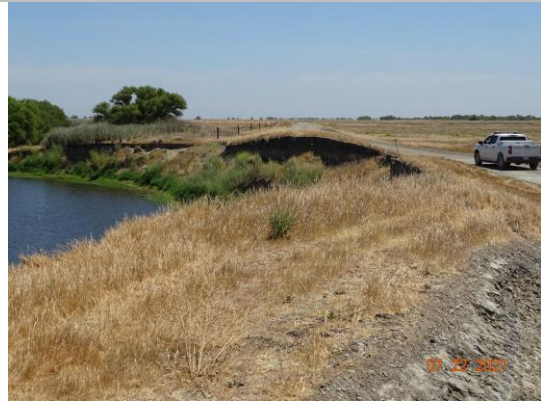
Photo 2 of 3 : SP_2022_NA0010_119_1_20220308_00002.jpg

7/22/2021: View of the eroded levee looking upstream.

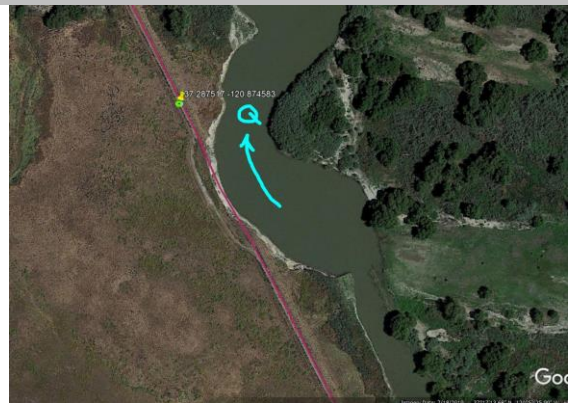
Photo 3 of 3 : SP_2022_NA0010_119_1_20220308_00003.jpg

8/20/2020: Aerial view of the erosion site (Google Earth Imagery from 7/18/2019).

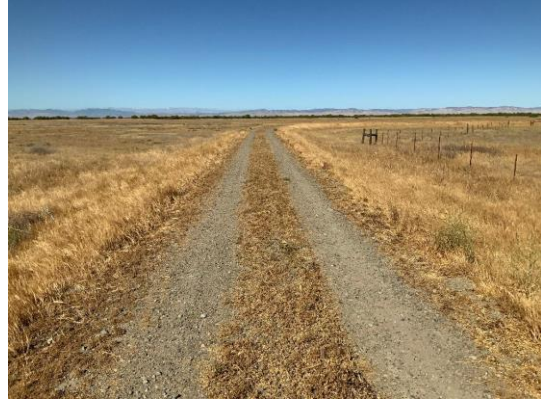
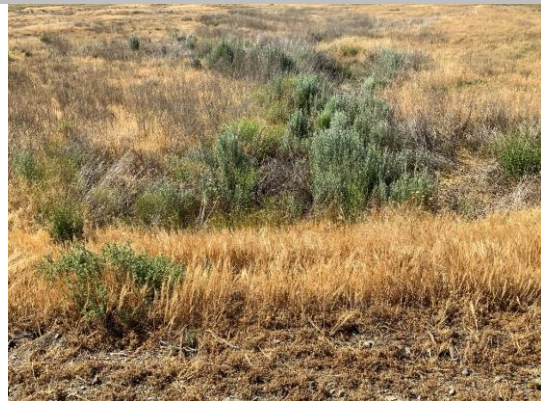
Levee crown looking downstream.

LS view: Toe from crown.

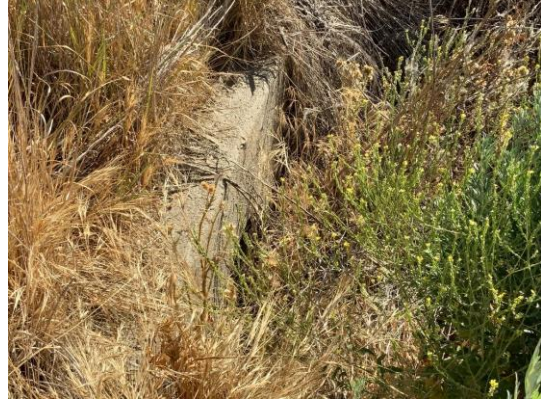
Photo 3 of 3 : UCIP_SP_2022_70935_100076.jpg

Comment Code						
Inspector Comment						
FS_ID:70935 DS_ID:19654 EP_NO: N/A Repair Type: Non-Urgent Crossing Status: Found UCIP Comments: 06/8/2021 The record remains Non-Urgent. Dense vegetation on LS slope, could not inspect pipe inlet, recommend clearing. No permit was found authorizing this encroachment. CVFPB will need to review crossing to determine owner. The UCIP inspection was completed with GEI staff, P. Espinoza. (H. Dunn ? GEI) 05/01/2014 Dense vegetation limits the inspector's visibility to identify signs of pipe failure (leaks) along the slope. Recommend removing vegetation along pipe alignment to conduct proper inspection of structure. Sediment buildup in pipe recommend clearing. (O. Magana - DWR UCIP) FIELD_STRUCT_DESC: 24-inch corrugated metal gravity drainage pipe (CMP) through the levee, 8.6 feet below the crown. Flap gate on the waterside (WS) end. Brass cap No. 137 bench mark (BM) on the headwall on the landside (LS). [Additional Reference(s): DWR Levee Log, 2002, (HLM 1.03). USACE San Joaquin O&M Manual, Unit No. 601, Part No. 1, 1967, Amended in 1978, Revised 20 June 1985, (HLM 1.02)]. FS Date: 6/8/2021

LS view: Close up of pipe inlet and headwall, covered by vegetation.

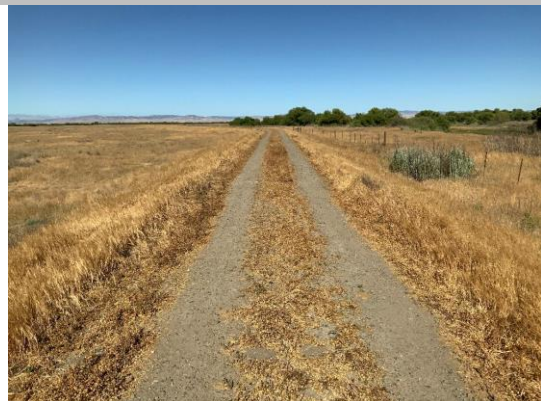
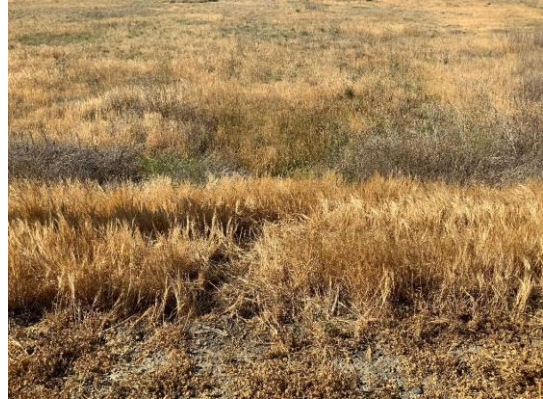
FS_ID:70936
DS_ID:19655
EP_NO: N/A
Repair Type: Non-Urgent
Crossing Status: Found
UCIP Comments: 06/8/2021 The record remains Non-Urgent. Dense vegetation over LS pipe inlet, recommend clearing out for easier pipe inspection. No permit was found authorizing this encroachment. CVFPB will need to review crossing to determine owner. The UCIP inspection was completed with GEI staff, P. Espinoza. (H. Dunn ? GEI)

05/01/2014 Dense vegetation limits the inspector's visibility to identify signs of pipe failure (leaks) along the slope. Recommend removing vegetation along pipe alignment to conduct proper inspection of structure. (O. Magana - DWR UCIP)

Levee crown looking downstream.

LS view: Toe from crown.

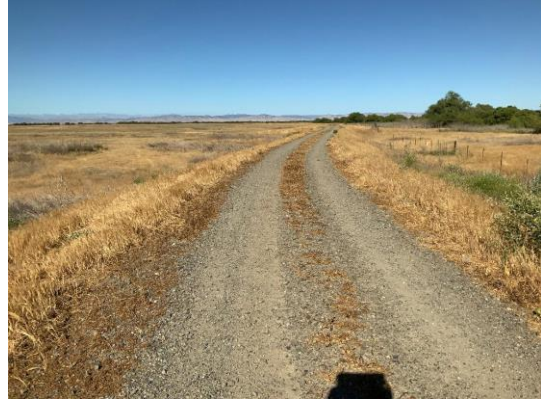
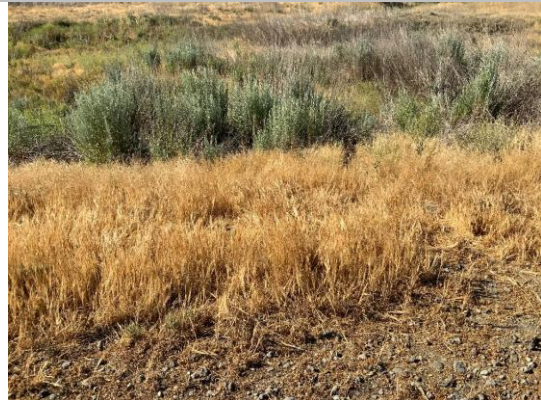
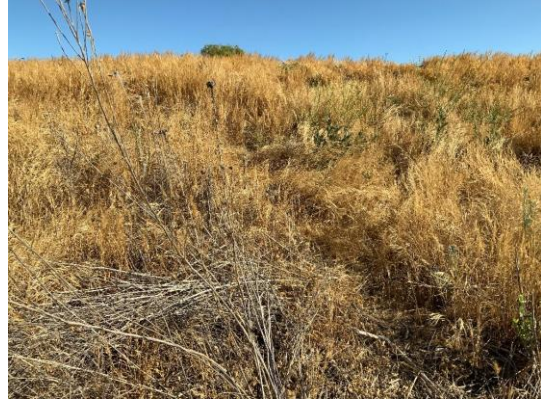
Comment Code						
Inspector Comment						
FS_ID:70937 DS_ID:19656 EP_NO: N/A Repair Type: Non-Urgent Crossing Status: Found UCIP Comments: 06/8/2021 The record remains Non-Urgent. Dense LS vegetation limits inspection of pipe inlet, headwall and inlet not visible at all, recommend clearing. WS flapgate seen with vegetation sticking out of it, recommend removal. No permit was found authorizing this encroachment. CVFPB will need to review crossing to determine owner. The UCIP inspection was completed with GEI staff, P. Espinoza. (H. Dunn ? GEI) 05/01/2014 Dense vegetation limits the inspector's visibility to identify signs of pipe failure (leaks) along the slope. Recommend removing vegetation along pipe alignment to conduct proper inspection of structure. (O. Magana - DWR UCIP) FIELD_STRUCT_DESC: 36-inch corrugated metal gravity drainage pipe (CMP) through the levee, 14.6 feet below the crown. Flap gate on the waterside (WS) end. Brass cap No. 135 bench mark (BM) on the headwall on the landside (LS). [Additional Reference(s): DWR Levee Log, 2002, (HLM 1.36). USACE San Joaquin O&M Manual, Unit No. 601, Part No. 1, 1967, Amended in 1978, Revised 20 June 1985, (HLM 1.34)]. FS Date: 6/8/2021

Levee crown looking downstream.

LS view: Toe from crown.

LS view: Slope from just above toe.

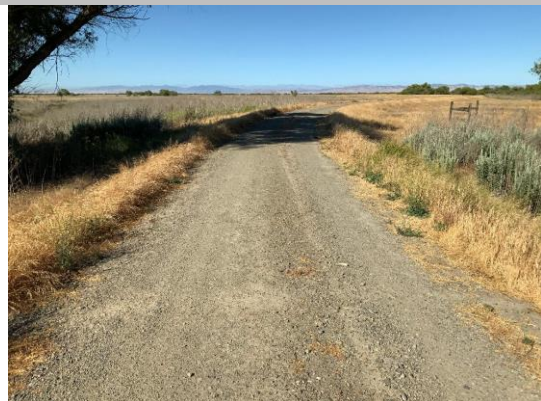
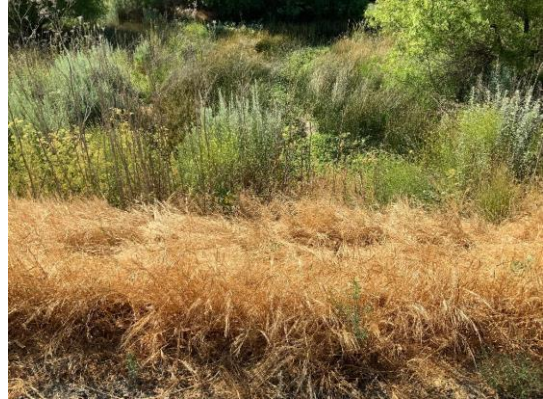
FS_ID:70938
 DS_ID:19657
 EP_NO: N/A
 Repair Type: Non-Urgent
 Crossing Status: Found
 UCIP Comments: 06/8/2021 The record remains Non-Urgent. Both WS and LS pipe ends are heavily vegetated. Headwalls and flapgate were just barely visible, recommend removal of vegetation on both sides. No permit was found authorizing this encroachment. CVFPB will need to review crossing to determine owner. The UCIP inspection was completed with GEI staff, P. Espinoza. (H. Dunn ? GEI) 05/01/2014 Dense vegetation limits the inspector's visibility to identify signs of pipe failure (leaks) along the slope. Recommend removing vegetation along pipe alignment to conduct proper inspection of structure. (O. Magana - DWR UCIP)
 FIELD_STRUCT_DESC: 24-inch corrugated metal gravity drainage pipe (CMP) through the levee, 10.2 feet below the crown. Flap gate on the waterside (WS) end. Brass cap No. 135 bench mark (BM) on the headwall on the landside (LS). [Additional Reference(s): DWR Levee Log, 2002 (HLM 1.63). USACE San Joaquin O&M Manual, Unit No. 601, Part No. 1, 1967, Amended in 1978, Revised 20 June 1985, (HLM 1.62)].

Levee crown looking downstream.

LS view: Toe from crown.

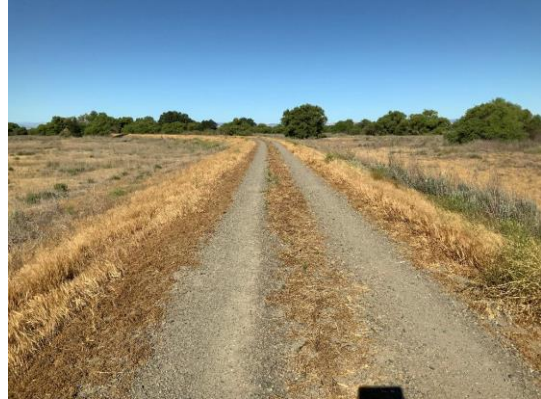
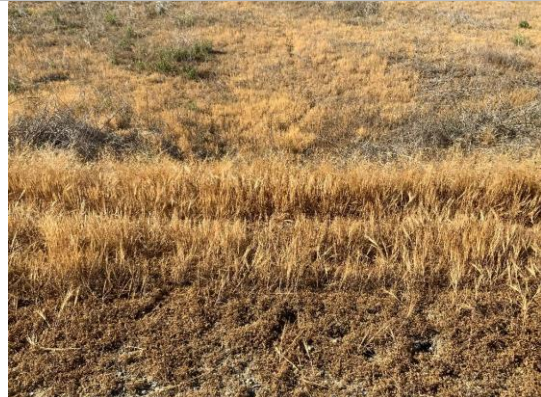
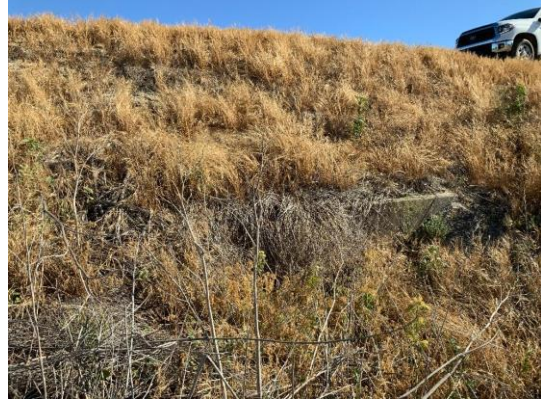
Comment Code						
Inspector Comment						
FS_ID:70939 DS_ID:19658 EP_NO: N/A Repair Type: Non-Urgent Crossing Status: Found UCIP Comments: 06/8/2021 The record remains Non-Urgent. Dense vegetation covering LS pipe inlet, recommend removal. No permit was found authorizing this encroachment. CVFPB will need to review crossing to determine owner. The UCIP inspection was completed with GEI staff, P. Espinoza. (H. Dunn ? GEI) 05/01/2014 Dense vegetation limits the inspector's visibility to identify signs of pipe failure (leaks) along the slope. Recommend removing vegetation along pipe alignment to conduct proper inspection of structure. (O. Magana - DWR UCIP) FIELD_STRUCT_DESC: 24-inch corrugated metal gravity drainage pipe (CMP) through the levee, 10.7 feet below the crown. Flap gate on the waterside (WS) end. Brass cap No. 135 bench mark (BM) on the headwall on the landside (LS). [Additional Reference(s): DWR Levee Log, 2002, (HLM 1.88). USACE San Joaquin O&M Manual, Unit No. 601, Part No. 1, 1967, Amended in 1978, Revised 20 June 1985, (HLM 1.86)]. FS Date: 6/8/2021

Levee crown looking downstream.

LS view: Toe from crown.

LS view: Slope and headwall from toe.

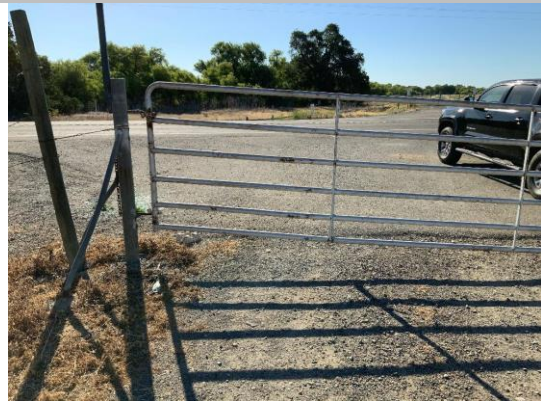
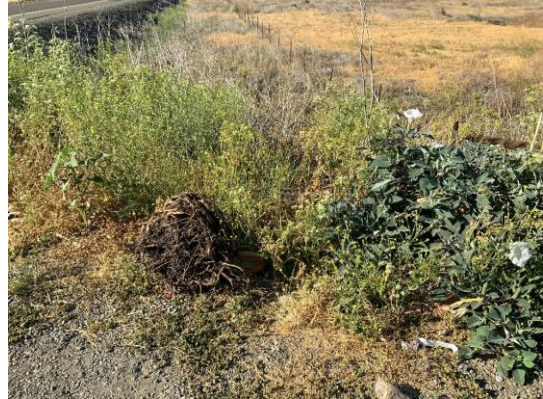
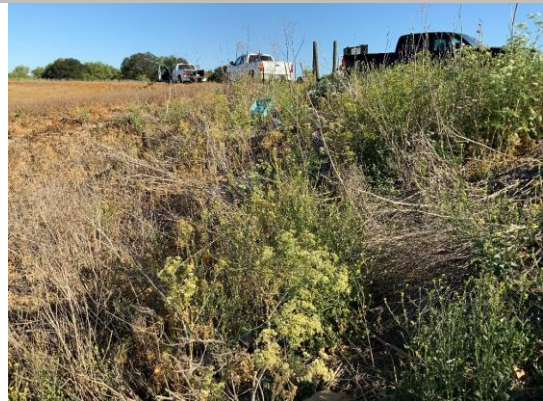
FS_ID:70940
 DS_ID:19659
 EP_NO: N/A
 Repair Type: Non-Urgent
 Crossing Status: Found
 UCIP Comments: 06/8/2021 The record remains Non-Urgent. LS pipe inlet covered by trash and debris, recommend clearing out. No permit was found authorizing this encroachment. CVFPB will need to review crossing to determine owner. The UCIP inspection was completed with GEI staff, P. Espinoza. (H. Dunn ? GEI) 05/01/2014 Dense vegetation limits the inspector's visibility to identify signs of pipe failure (leaks) along the slope. Recommend removing vegetation along pipe alignment to conduct proper inspection of structure. (O. Magana - DWR UCIP)
 FIELD_STRUCT_DESC: 24-inch corrugated metal gravity drainage pipe (CMP) through the levee, 7.0 feet below the crown. Flap gate on the waterside (WS) end. Brass cap No. 135 bench mark (BM) on the headwall on the landside (LS). [Additional Reference(s): DWR Levee Log, 2002, (HLM 2.32). USACE San Joaquin O&M Manual, Unit No. 601, Part No. 1, 1967, Amended in 1978, Revised 20 June 1985, (HLM 2.30)].

Levee crown looking upstream.

LS view: Toe from crown.

LS view: Slope from toe.

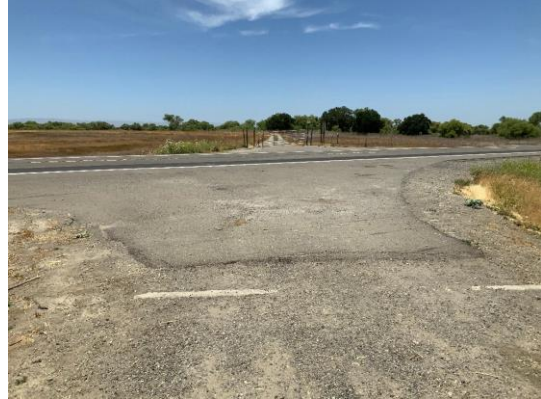
Photo 1 of 3 : UCIP_SP_2022_70941_100116.jpg

Comment Code						
Inspector Comment						
FS_ID:70941 DS_ID:19660 EP_NO: N/A Repair Type: Non-Urgent Crossing Status: Found UCIP Comments: 06/8/2021 The record remains Non-Urgent. Vegetation present at pipe inlet on LS, recommend removal. No permit was found authorizing this encroachment. CVFPB will need to review crossing to determine owner. The UCIP inspection was completed with GEI staff, P. Espinoza. (H. Dunn ? GEI) 05/01/2014 Dense vegetation limits the inspector's visibility to identify signs of pipe failure (leaks) along the slope. Recommend removing vegetation along pipe alignment to conduct proper inspection of structure. (O. Magana - DWR UCIP) FIELD_STRUCT_DESC: 24-inch corrugated metal gravity drainage pipe (CMP) through the levee, 7.0 feet below the crown. Flap gate on the waterside (WS) end. Brass cap No. 135 bench mark (BM) on the headwall on the landside (LS). [Additional Reference(s): DWR Levee Log, 2002, (HLM 2.34). USACE San Joaquin O&M Manual, Unit No. 601, Part No. 1, 1967, Amended in 1978, Revised 20 June 1985, (HLM 2.32)]. FS Date: 6/8/2021

Levee crown looking downstream.
