**Flood Control Project Maintenance
Levee Inspections**

Maintenance Issue Types Only, Levee Inspection Report By Mile - Spring 2022

Lower San Joaquin Levee District

Waterway	Bank	Unit Miles	Inspection Start/End	Inspector
Unit No. 01 San Joaquin River	Right	22.52	04/05/2022 04/05/2022	Corey Fujitani

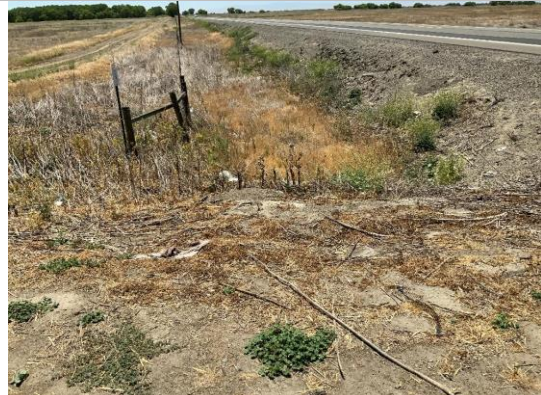
Photo 2 of 3 : UCIP_SP_2022_70941_100117.jpg

Comment Code						
Inspector Comment						
FS_ID:70941 DS_ID:19660 EP_NO: N/A Repair Type: Non-Urgent Crossing Status: Found UCIP Comments: 06/8/2021 The record remains Non-Urgent. Vegetation present at pipe inlet on LS, recommend removal. No permit was found authorizing this encroachment. CVFPB will need to review crossing to determine owner. The UCIP inspection was completed with GEI staff, P. Espinoza. (H. Dunn ? GEI) 05/01/2014 Dense vegetation limits the inspector's visibility to identify signs of pipe failure (leaks) along the slope. Recommend removing vegetation along pipe alignment to conduct proper inspection of structure. (O. Magana - DWR UCIP) FIELD_STRUCT_DESC: 24-inch corrugated metal gravity drainage pipe (CMP) through the levee, 7.0 feet below the crown. Flap gate on the waterside (WS) end. Brass cap No. 135 bench mark (BM) on the headwall on the landside (LS). [Additional Reference(s): DWR Levee Log, 2002, (HLM 2.34). USACE San Joaquin O&M Manual, Unit No. 601, Part No. 1, 1967, Amended in 1978, Revised 20 June 1985, (HLM 2.32)]. FS Date: 6/8/2021

LS view: Toe from crown.

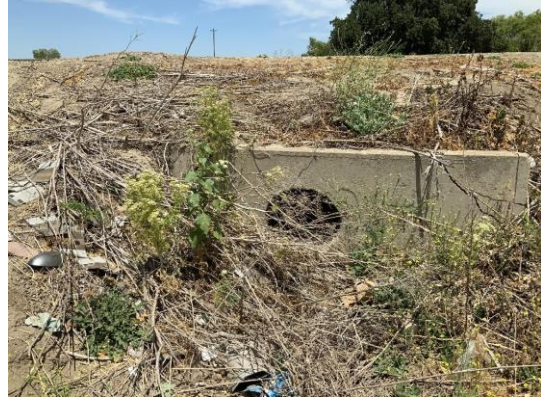
Photo 3 of 3 : UCIP_SP_2022_70941_100118.jpg

LS view: Slope and headwall at toe.

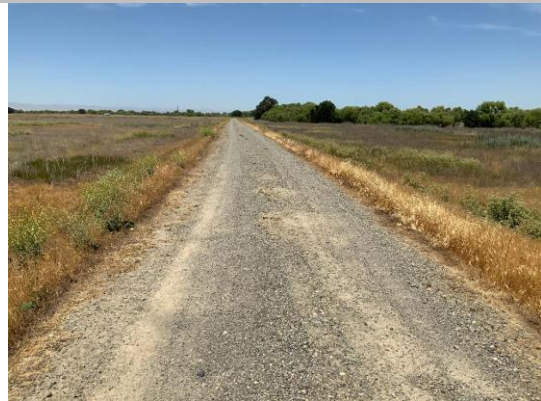
Photo 1 of 3 : UCIP_SP_2022_70942_100127.jpg

FS_ID:70942
DS_ID:19661
EP_NO: N/A
Repair Type: Non-Urgent
Crossing Status: Found
UCIP Comments: 06/8/2021 The record remains Non-Urgent.
Vegetation on LS and WS limited close up inspection of flapgate and pipe inlet. No permit was found authorizing this encroachment. CVFPB will need to review crossing to determine owner. The UCIP inspection was completed with GEI staff, P. Espinoza. (H. Dunn ? GEI)

05/01/2014 Dense vegetation limits the inspector's visibility to identify signs of pipe failure (leaks) along the slope. Recommend removing vegetation along pipe alignment to conduct proper inspection of structure. (O. Magana - DWR UCIP)
FIELD_STRUCT_DESC: 24-inch corrugated metal gravity drainage pipe (CMP) through the levee, 10.0 feet below the crown. Flap gate on the waterside (WS) end. Brass cap No. 130 bench mark (BM) on the headwall on the landside (LS). [Additional Reference(s): DWR Levee Log, 2002, (HLM 2.60). USACE San Joaquin O&M Manual, Unit No. 601, Part No. 1, 1967, Amended in 1978, Revised 20 June 1985, (HLM 2.59)].
FS Date: 6/8/2021

Levee crown looking downstream.

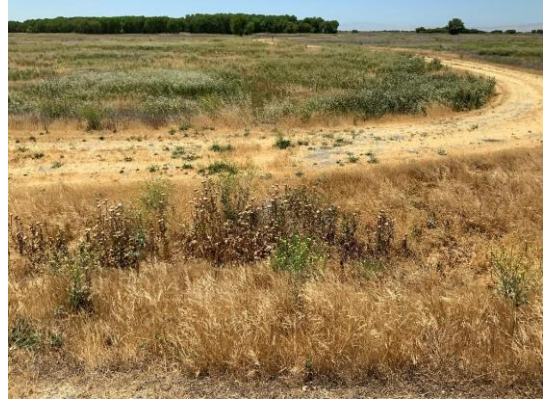
Photo 2 of 3 : UCIP_SP_2022_70942_100126.jpg

LS view: Toe from crown.

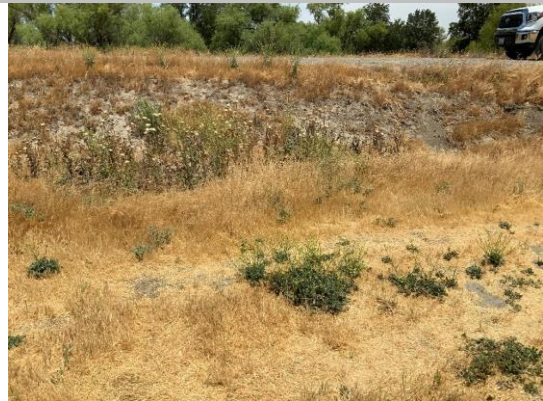
Photo 3 of 3 : UCIP_SP_2022_70942_100121.jpg

LS view: Slope from toe.

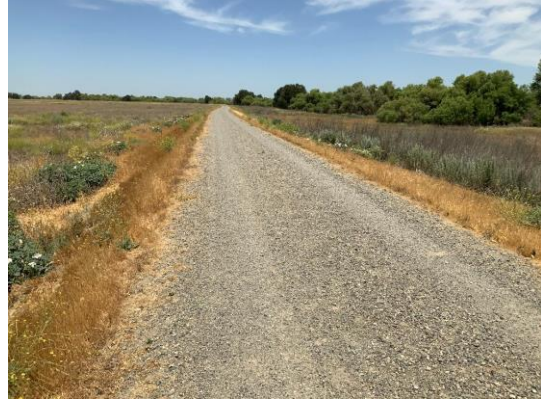
Photo 1 of 3 : UCIP_SP_2022_70943_100132.jpg

Comment Code						
Inspector Comment						
FS_ID:70943 DS_ID:19662 EP_NO: N/A Repair Type: Non-Urgent Crossing Status: Found UCIP Comments: 06/7/2021 The record remains Non-Urgent. LS pipe inlet completely buried in sediment, recommend clearing out. No permit was found authorizing this encroachment. CVFPB will need to review crossing to determine owner. The UCIP inspection was completed with GEI staff, P. Espinoza. (H. Dunn ? GEI) 05/01/2014 Dense vegetation limits the inspector's visibility to identify signs of pipe failure (leaks) along the slope. Recommend removing vegetation along pipe alignment to conduct proper inspection of structure. (O. Magana - DWR UCIP) FIELD_STRUCT_DESC: 24-inch corrugated metal gravity drainage pipe (CMP) through the levee, 10.0 feet below the crown. Flap gate on the waterside (WS) end. Brass cap No. 130 bench mark (BM) on the headwall on the landside (LS). [Additional Reference(s): DWR Levee Log, 2002, (HLM 2.97). USACE San Joaquin O&M Manual, Unit No. 601, Part No. 1, 1967, Amended in 1978, Revised 20 June 1985, (HLM 2.96)]. FS Date: 6/7/2021

Levee crown looking downstream.

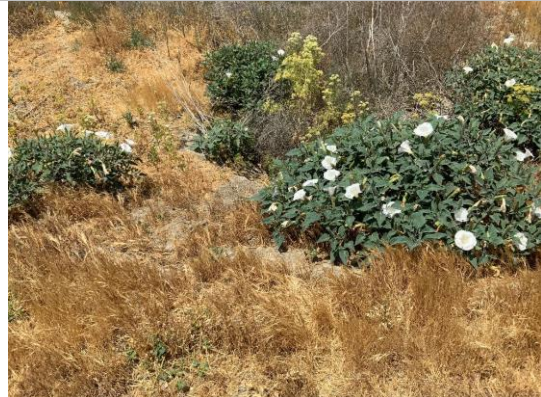
Photo 2 of 3 : UCIP_SP_2022_70943_100133.jpg

LS view: Toe from crown.

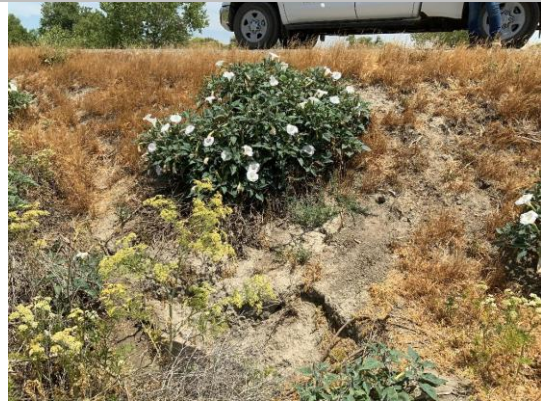
Photo 3 of 3 : UCIP_SP_2022_70943_100134.jpg

LS view: Slope from toe.

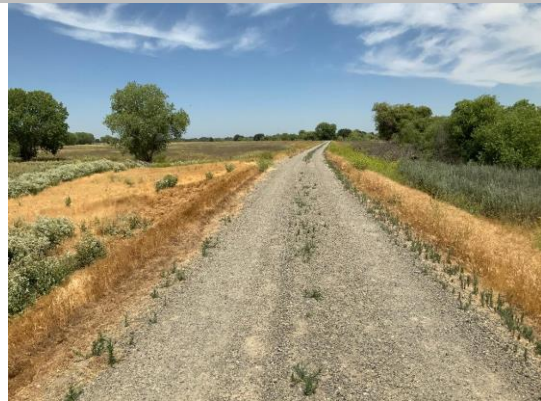
Photo 1 of 3 : UCIP_SP_2022_70944_100137.jpg

FS_ID:70944
DS_ID:19665
EP_NO: N/A
Repair Type: Non-Urgent
Crossing Status: Found
UCIP Comments: 06/7/2021 The record remains Non-Urgent. Dense vegetation limited view and inspection of LS pipe inlet. Recommend removal of LS vegetation. No permit was found authorizing this encroachment. CVFPB will need to review crossing to determine owner. The UCIP inspection was completed with GEI staff, P. Espinoza. (H. Dunn ? GEI) 05/01/2014 Dense vegetation limits the inspector's visibility to identify signs of pipe failure (leaks) along the slope. Recommend removing vegetation along pipe alignment to conduct proper inspection of structure. (O. Magana - DWR UCIP)
FIELD_STRUCT_DESC: 24-inch corrugated metal gravity drainage pipe (CMP) through the levee, 12.4 feet below the crown. Flap gate on the waterside (WS) end. Brass cap No. 130 bench mark (BM) on the headwall on the landside (LS). [Additional Reference(s): DWR Levee Log, 2002, (HLM 3.31). USACE San Joaquin O&M Manual, Unit No. 601, Part No. 1, 1967, Amended in 1978, Revised 20 June 1985, (HLM 3.29)].

Levee crown looking downstream.

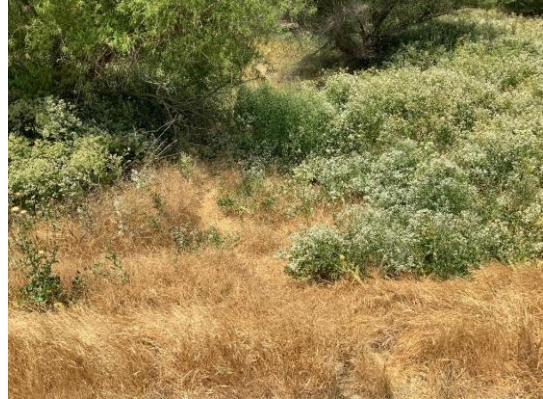
Photo 2 of 3 : UCIP_SP_2022_70944_100142.jpg

LS view: Toe from crown, pipe end not visible.

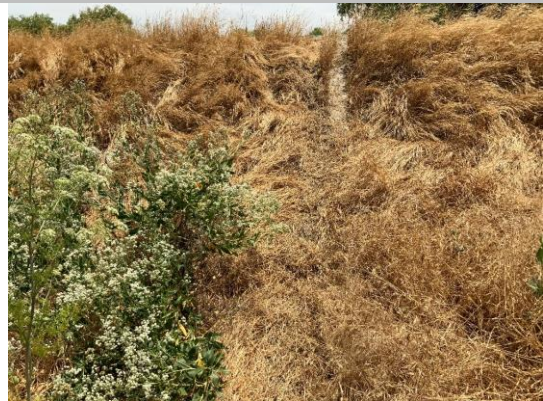
Photo 3 of 3 : UCIP_SP_2022_70944_100136.jpg

LS view: Slope from toe.

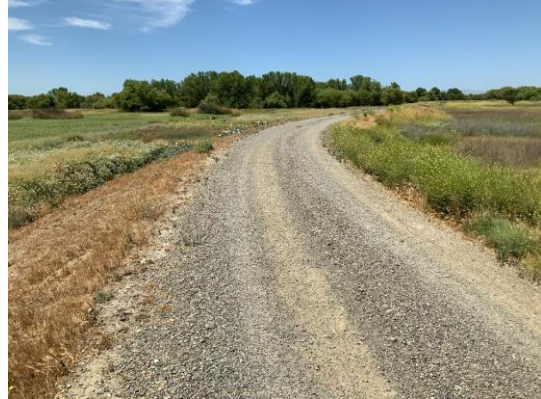
Photo 1 of 3 : UCIP_SP_2022_70945_100146.jpg

Comment Code					
Inspector Comment					
FS_ID:70945 DS_ID:19666 EP_NO: N/A Repair Type: Non-Urgent Crossing Status: Found UCIP Comments: 06/7/2021 The record remains Non-Urgent. LS has boards blocking the open pipe inlet but there is significant sediment and vegetation on the other side of the boards, recommend cleaning around. No permit was found authorizing this encroachment. CVFPB will need to review crossing to determine owner. The UCIP inspection was completed with GEI staff, P. Espinoza. (H. Dunn ? GEI) 05/01/2014 Dense vegetation limits the inspector's visibility to identify signs of pipe failure (leaks) along the slope. Recommend removing vegetation along pipe alignment to conduct proper inspection of structure. (O. Magana - DWR UCIP) FIELD_STRUCT_DESC: 24-inch corrugated metal gravity drainage pipe (CMP) through the levee, 10.0 feet below the crown. Flap gate on the waterside (WS) end. Brass cap No. 130 bench mark (BM) on the headwall on the landside (LS). [Additional Reference(s): DWR Levee Log, 2002, (HLM 3.63). USACE San Joaquin O&M Manual, Unit No. 601, Part No. 1, 1967, Amended in 1978, Revised 20 June 1985, (HLM 3.62)]. FS Date: 6/7/2021

Levee crown looking downstream.

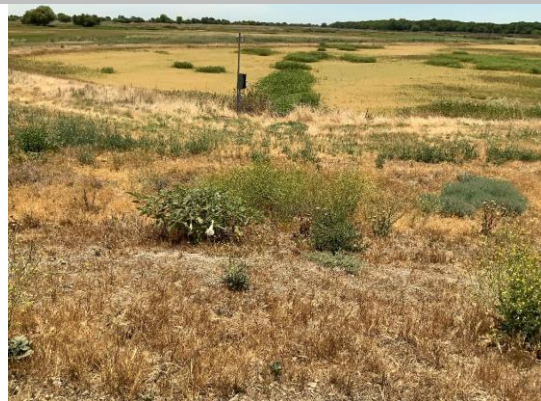
Photo 2 of 3 : UCIP_SP_2022_70945_100148.jpg

LS view: Toe from crown.

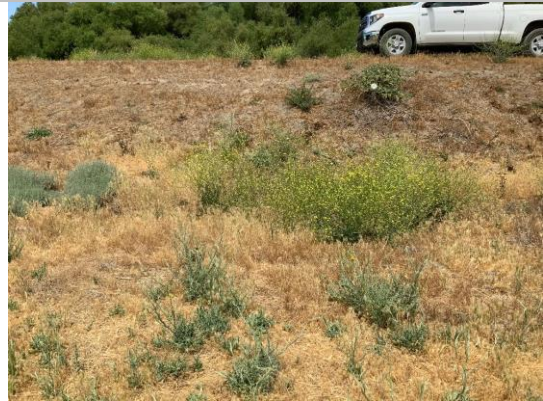
Photo 3 of 3 : UCIP_SP_2022_70945_100149.jpg

LS view: Slope from toe.

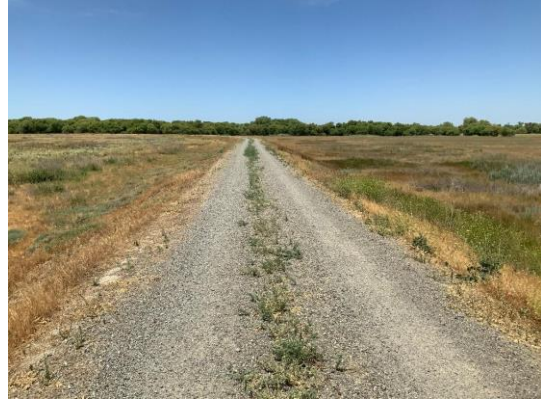
Photo 1 of 3 : UCIP_SP_2022_70946_100154.jpg

Comment Code						
Inspector Comment						
FS_ID:70946 DS_ID:19667 EP_NO: N/A Repair Type: Non-Urgent Crossing Status: Found UCIP Comments: 06/7/2021 The record remains Non-Urgent. Dense vegetation around LS pipe inlet, recommend removal. No permit was found authorizing this encroachment. CVFPB will need to review crossing to determine owner. The UCIP inspection was completed with GEI staff, P. Espinoza. (H. Dunn ? GEI) 05/01/2014 Signs of erosion or sink hole present on landward toe--Need to contact owner. Dense vegetation limits the inspector's visibility to identify signs of pipe failure (leaks) along the slope. Recommend removing vegetation along pipe alignment to conduct proper inspection of structure. (O. Magana - DWR UCIP) FIELD_STRUCT_DESC: 24-inch corrugated metal gravity drainage pipe (CMP) through the levee, 8.6 feet below the crown. Flap gate on the waterside (WS) end. Brass cap No. 130 bench mark (BM) on the headwall on the landside (LS). [Additional Reference(s): DWR Levee Log, 2002, (HLM 3.96). USACE San Joaquin O&M Manual, Unit No. 601, Part No. 1, 1967, Amended in 1978, Revised 20 June 1985, (HLM 3.95)]. FS Date: 6/7/2021

Levee crown looking downstream.

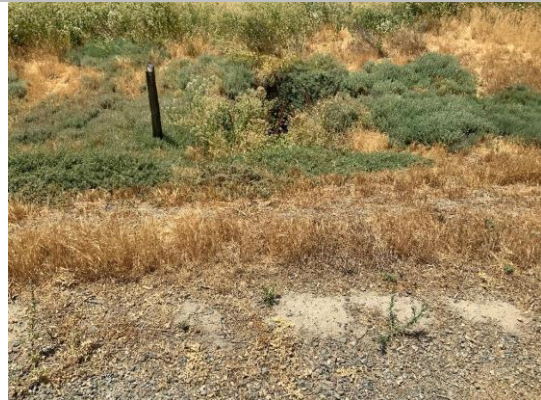
Photo 2 of 3 : UCIP_SP_2022_70946_100155.jpg

LS view: Toe from crown.

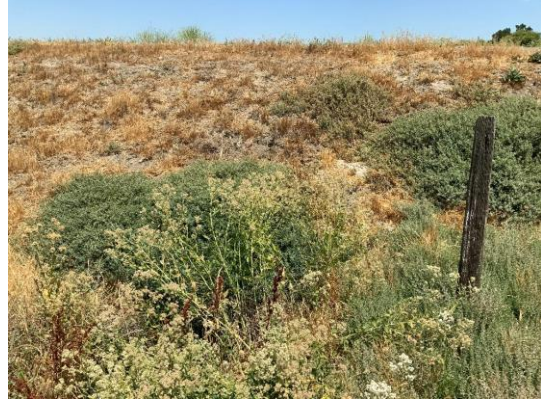
Photo 3 of 3 : UCIP_SP_2022_70946_100156.jpg

LS view: Slope from toe.

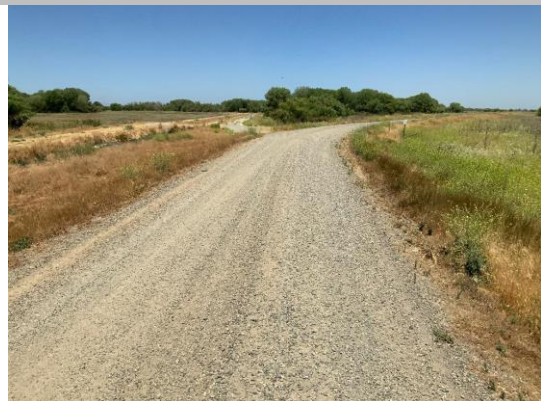
Photo 1 of 3 : UCIP_SP_2022_70947_100159.jpg

FS_ID:70947
 DS_ID:19668
 EP_NO: N/A
 Repair Type: Non-Urgent
 Crossing Status: Found
 UCIP Comments: 06/7/2021 The record remains Non-Urgent. Limited inspection on WS due to dense vegetation, flapgate not visible, recommend clearing away. Limited inspection on LS due to canal limiting access to inlet. No permit was found authorizing this encroachment. CVFPB will need to review crossing to determine owner. The UCIP inspection was completed with GEI staff, P. Espinoza. (H. Dunn ? GEI) 05/01/2014 Dense vegetation limits the inspector's visibility to identify signs of pipe failure (leaks) along the slope. Recommend removing vegetation along pipe alignment to conduct proper inspection of structure. (O. Magana - DWR UCIP)
 FIELD_STRUCT_DESC: 24-inch corrugated metal gravity drainage pipe (CMP) through the levee, 8.0 feet below the crown. Flap gate on the waterside (WS) end. Brass cap No. 125 bench mark (BM) on the headwall on the landside (LS). [Additional Reference(s): DWR Levee Log, 2002, (HLM 5.45). USACE San Joaquin O&M Manual, Unit No. 601, Part No. 1, 1967, Amended in 1978, Revised 20 June 1985, (HLM 5.43)].

Levee crown looking downstream.

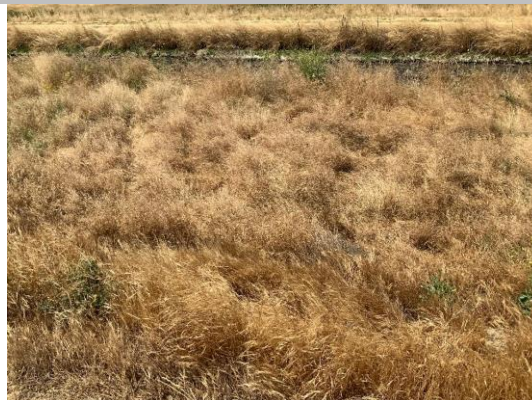
Photo 2 of 3 : UCIP_SP_2022_70947_100162.jpg

LS view: Toe from crown.

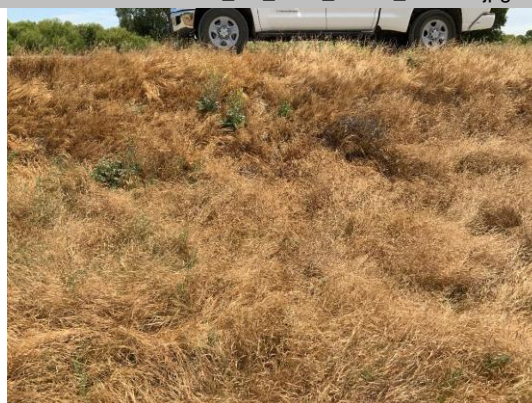
Photo 3 of 3 : UCIP_SP_2022_70947_100163.jpg

LS view: Slope from toe.

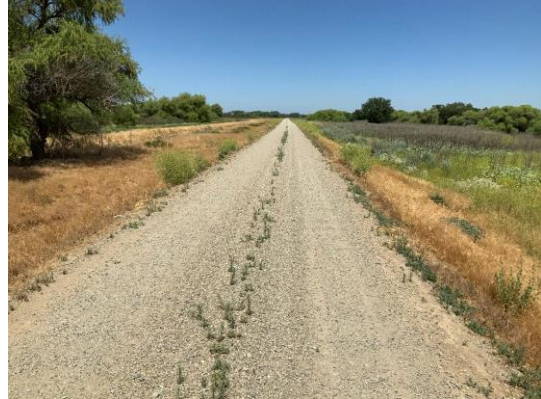
Photo 1 of 3 : UCIP_SP_2022_70948_100164.jpg

Comment Code						
Inspector Comment						
FS_ID:70948 DS_ID:19669 EP_NO: N/A Repair Type: Non-Urgent Crossing Status: Found UCIP Comments: 06/7/2021 The record remains Non-Urgent. LS pipe inlet completely buried under sediment, recommend clearing out. No permit was found authorizing this encroachment. CVFPB will need to review crossing to determine owner. The UCIP inspection was completed with GEI staff, P. Espinoza. (H. Dunn ? GEI) 05/01/2014 Dense vegetation limits the inspector's visibility to identify signs of pipe failure (leaks) along the slope. Recommend removing vegetation along pipe alignment to conduct proper inspection of structure. (O. Magana - DWR UCIP) FIELD_STRUCT_DESC: 24-inch corrugated metal gravity drainage pipe (CMP) through the levee, 7.7 feet below the crown. Flap gate on the waterside (WS) end. Brass cap No. 125 bench mark (BM) on the headwall on the landside (LS). [Additional Reference(s): DWR Levee Log, 2002, (HLM 6.06). USACE San Joaquin O&M Manual, Unit No. 601, Part No. 1, 1967, Amended in 1978, Revised 20 June 1985, (HLM 6.06)]. FS Date: 6/7/2021

Levee crown looking downstream.

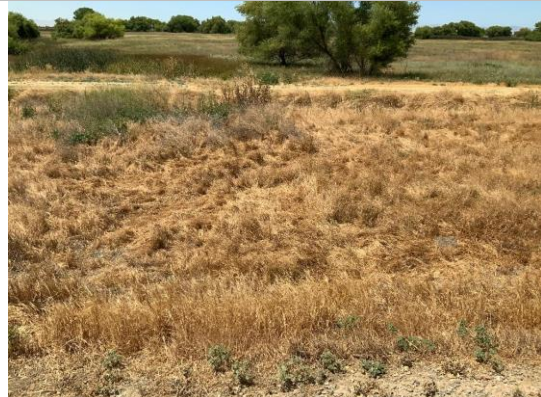
Photo 2 of 3 : UCIP_SP_2022_70948_100168.jpg

LS view: Toe from crown.

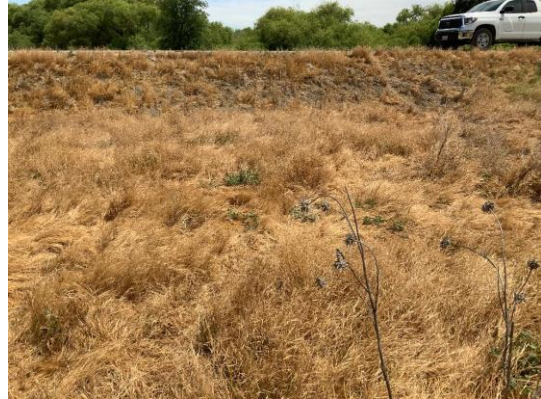
Photo 3 of 3 : UCIP_SP_2022_70948_100169.jpg

LS view: Slope from toe.

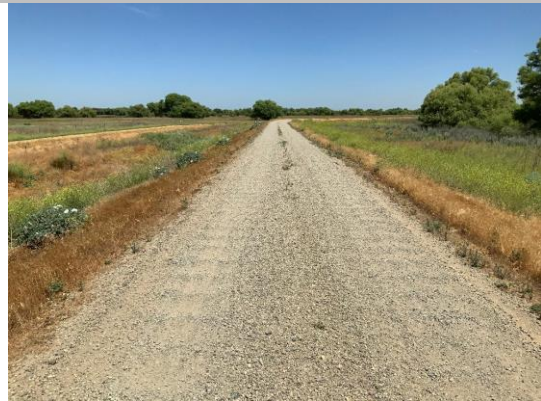
Photo 1 of 3 : UCIP_SP_2022_70949_100173.jpg

FS_ID:70949
DS_ID:19670
EP_NO: N/A
Repair Type: Non-Urgent
Crossing Status: Found
UCIP Comments: 06/7/2021 The record remains Non-Urgent. Limited inspection on LS due to canal and inability to access. No permit was found authorizing this encroachment. CVFPB will need to review crossing to determine owner. The UCIP inspection was completed with GEI staff, P. Espinoza. (H. Dunn ? GEI) 05/01/2014 Dense vegetation limits the inspector's visibility to identify signs of pipe failure (leaks) along the slope. Recommend removing vegetation along pipe alignment to conduct proper inspection of structure. (O. Magana - DWR UCIP)
FIELD_STRUCT_DESC: 24-inch corrugated metal gravity drainage pipe (CMP) through the levee, 7.7 feet below the crown. Flap gate on the waterside (WS) end. Brass cap No. 125 bench mark (BM) on the headwall on the landside (LS). [Additional Reference(s): DWR Levee Log, 2002, (HLM 6.50). USACE San Joaquin O&M Manual, Unit No. 601, Part No. 1, 1967, Amended in 1978, Revised 20 June 1985, (HLM 6.50)].

Levee crown looking downstream.

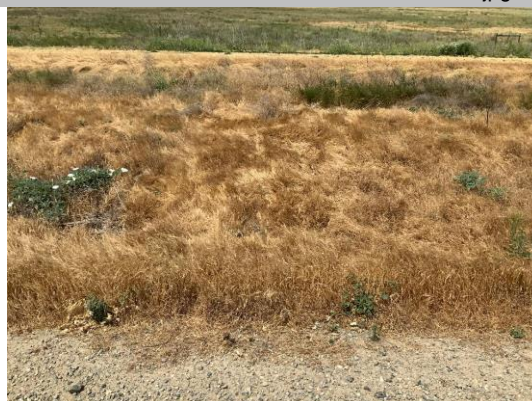
Photo 2 of 3 : UCIP_SP_2022_70949_100177.jpg

LS view: Toe from crown.

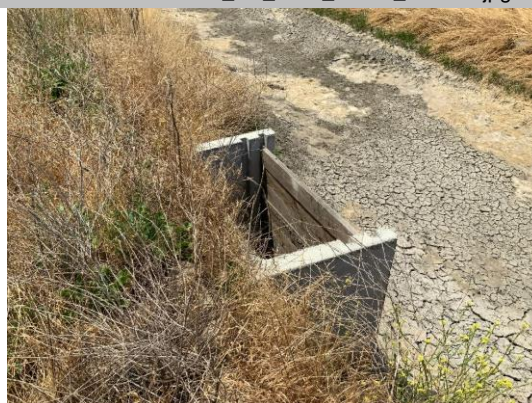
Photo 3 of 3 : UCIP_SP_2022_70949_100171.jpg

LS view: Close up of concrete box and pipe inlet.

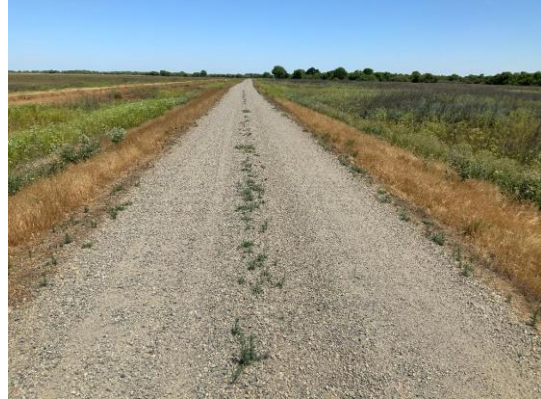
Photo 1 of 3 : UCIP_SP_2022_70950_100180.jpg

Comment Code					
Inspector Comment					
FS_ID:70950 DS_ID:19671 EP_NO: N/A Repair Type: Non-Urgent Crossing Status: Found UCIP Comments: 06/7/2021 The record remains Non-Urgent. Dense vegetation on WS limited inspection. LS pipe inlet is completely buried under sediment, recommend cleaning out. No permit was found authorizing this encroachment. CVFPB will need to review crossing to determine owner. The UCIP inspection was completed with GEI staff, P. Espinoza. (H. Dunn ? GEI) 05/01/2014 Dense vegetation limits the inspector's visibility to identify signs of pipe failure (leaks) along the slope. Recommend removing vegetation along pipe alignment to conduct proper inspection of structure. Pipe extension visible on landward side--need to contact owner for additional information about extension/modification. (O. Magana - DWR UCIP) FIELD_STRUCT_DESC: 24-inch corrugated metal gravity drainage pipe (CMP) through the levee, 12.6 feet below the crown. Flap gate on the waterside (WS) end. Brass cap No. 125 bench mark (BM) on the headwall on the landside (LS). [Additional Reference(s): DWR Levee Log, 2002, (HLM 7.06). USACE San Joaquin O&M Manual, Unit No. 601, Part No. 1, 1967, Amended in 1978, Revised 20 June 1985, (HLM 7.05)]. FS Date: 6/7/2021

Levee crown looking downstream.

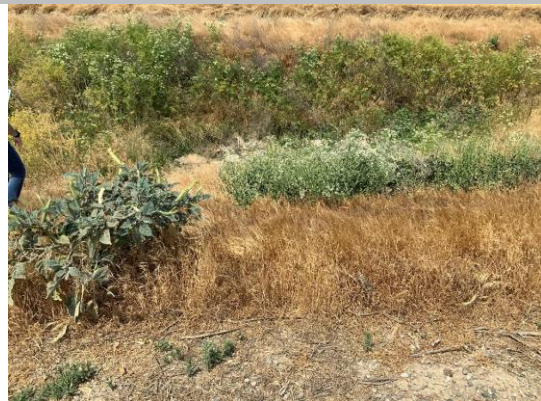
Photo 2 of 3 : UCIP_SP_2022_70950_100181.jpg

LS view: Toe from crown.

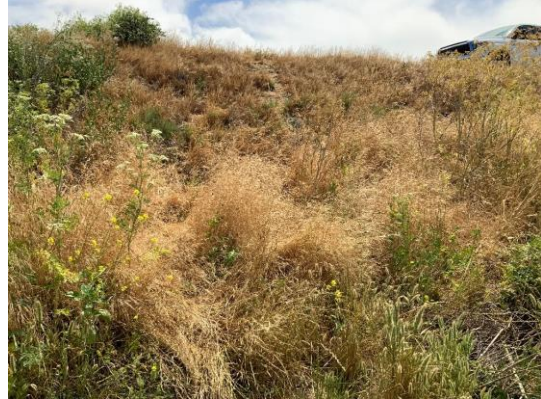
Photo 3 of 3 : UCIP_SP_2022_70950_100182.jpg

LS view: Slope from toe.

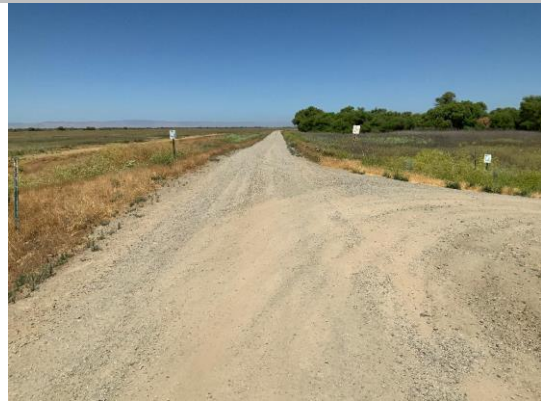
Photo 1 of 3 : UCIP_SP_2022_70952_100189.jpg

FS_ID:70952
DS_ID:19673
EP_NO: N/A
Repair Type: Non-Urgent
Crossing Status: Found
UCIP Comments: 06/7/2021 The record remains Non-Urgent. LS pipe end not visible, dense vegetation on both WS and LS ends, recommend removal. No permit was found authorizing this encroachment. CVFPB will need to review crossing to determine owner. The UCIP inspection was completed with GEI staff, P. Espinoza. (H. Dunn ? GEI)05/01/2014 Dense vegetation limits the inspector's visibility to identify signs of pipe failure (leaks) along the slope. Recommend removing vegetation along pipe alignment to conduct proper inspection of structure. (O. Magana - DWR UCIP)
FIELD_STRUCT_DESC: 24-inch corrugated metal gravity drainage pipe (CMP) through the levee, 8.0 feet below the crown. Flap gate on the waterside (WS) end. Brass cap No. 125 bench mark (BM) on the headwall on the landside (LS). [Additional Reference(s): DWR Levee Log, 2002, (HLM 7.78). USACE San Joaquin O&M Manual, Unit No. 601, Part No. 1, 1967, Amended in 1978, Revised 20 June 1985, (HLM 7.77)].

Levee crown looking downstream.

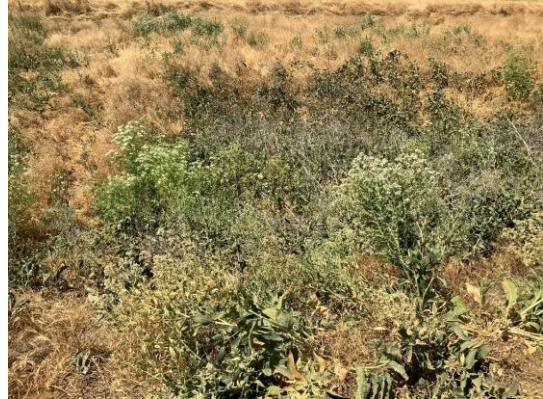
Photo 2 of 3 : UCIP_SP_2022_70952_100190.jpg

LS view: Headwall and inlet not visible under vegetation.

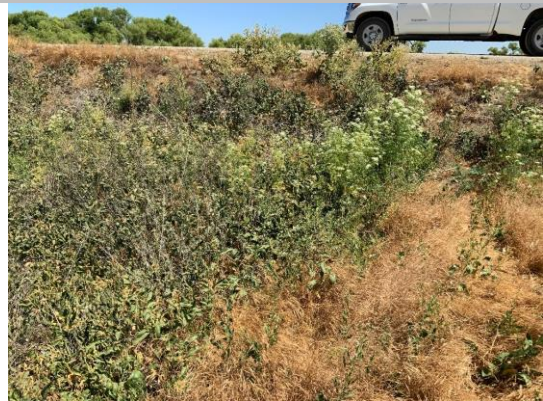
Photo 3 of 3 : UCIP_SP_2022_70952_100191.jpg

LS view: Slope from toe.

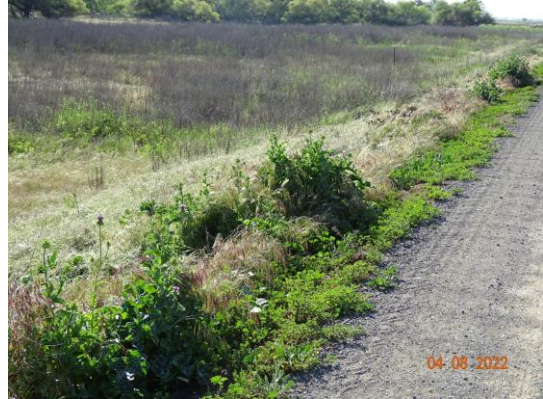
Photo 1 of 1 : SP_2022_NA0010_120_16_20220412_00049.jpg

LM Start	7.87	Rating **	M	Issue No.	16
LM End	11.16	Issue Type +	Ma	Location *	WS
Category	Earthen Levee			GPS Latitude/Longitude	
				Start	End
Item	Vegetation			37.231246 °	37.204359 °
				-120.811818 °	-120.771238 °
DWR ID	DWR_NA0010_02B_s_2022_16				
Comment Code					
V1 : Control annual grass and weeds on the levee slopes and easements.					
Inspector Comment

Looking upstream along the waterside slope. (Spring 2022)

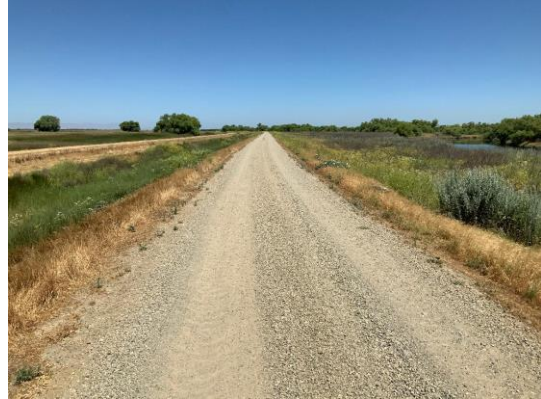
Photo 1 of 3 : UCIP_SP_2022_70953_100048.jpg

Comment Code						
Inspector Comment						
FS_ID:70953 DS_ID:19674 EP_NO: N/A Repair Type: Non-Urgent Crossing Status: Found UCIP Comments: 06/7/2021 Record remains Non-Urgent. DWR DMP internal inspection has not found pipe integrity issues. LOF of crossing is less or equal to 4.0. Recommend next video inspection in 5 years. LS headwall barely visible at toe due to dense vegetation. Dense vegetation also over WS flapgate. Limited inspection of both WS and LS pipe ends. Recommend removal of vegetation on both WS and LS. No permit was found authorizing this encroachment. CVFPB will need to review crossing to determine owner. The UCIP inspection was completed with GEI staff, P. Espinoza. (H. Dunn ? GEI) 05/14/2014 Dense vegetation limits the inspector's visibility to identify signs of pipe failure (leaks) along the slope and landward headwall. Recommend removing vegetation along pipe alignment and toe to conduct proper inspection of structure. Sediment buildup in pipe visible from landward side--recommend clearing. (O. Magana - DWR UCIP) FIELD_STRUCT_DESC: 24-inch corrugated metal gravity drainage pipe (CMP) through the levee, 9.0 feet below the crown. Flap gate on the waterside (WS) end. Brass cap No. 120 bench mark (BM) on the headwall on the landside (LS). [Additional Reference(s): DWR Levee Log, 2002, (HLM 8.17). USACE San Joaquin O&M Manual, Unit No. 601, Part No. 1, 1967, Amended in 1978, Revised 20 June 1985, (HLM 8.16)]. FS Date: 6/7/2021

Levee crown looking downstream.

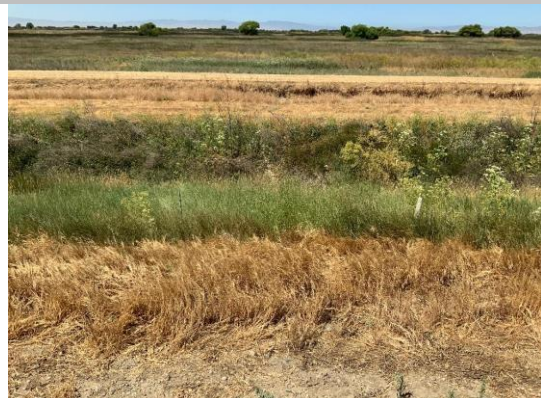
Photo 2 of 3 : UCIP_SP_2022_70953_100042.jpg

LS view: Slope from crown.

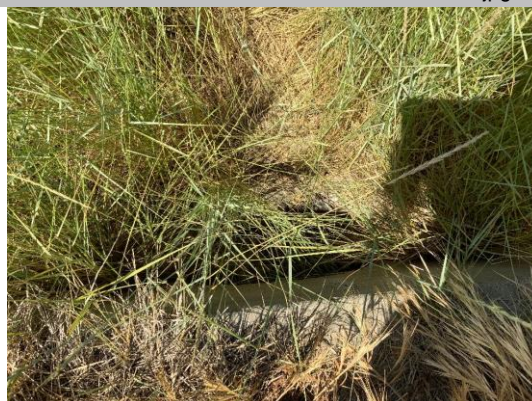
Photo 3 of 3 : UCIP_SP_2022_70953_100043.jpg

LS view: Headwall barely visible at toe.

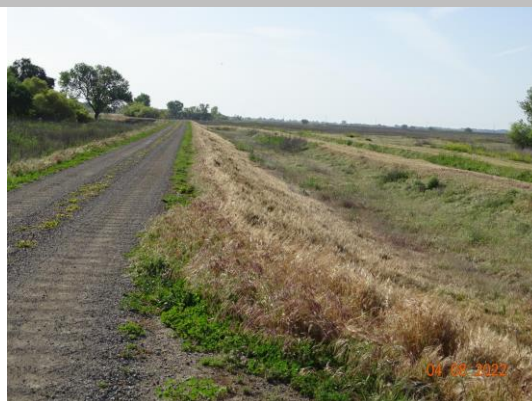
Photo 1 of 1 : SP_2022_NA0010_120_17_20220412_00050.jpg

LM Start	8.31	Rating **	M	Issue No.	17
LM End	11.16	Issue Type +	Ma	Location *	LS
Category	Earthen Levee			GPS Latitude/Longitude	
				Start	End
Item	Vegetation			37.226588 °	37.204391 °
				-120.806307 °	-120.771274 °
DWR ID	DWR_NA0010_02B_s_2022_17				
Comment Code					
V1 : Control annual grass and weeds on the levee slopes and easements.					
Inspector Comment

View of vegetation on the landside slope. (Spring 2022)

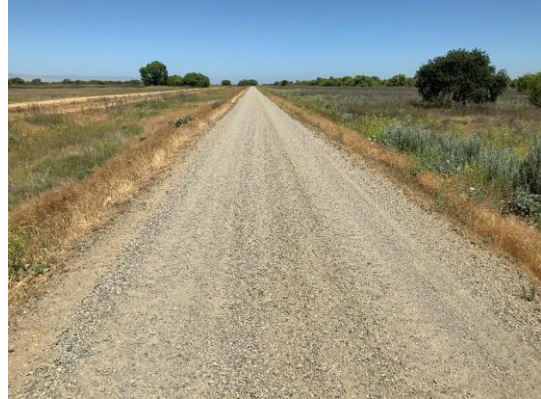
Photo 1 of 3 : UCIP_SP_2022_70954_100340.jpg

Comment Code						
Inspector Comment						
FS_ID:70954 DS_ID:19675 EP_NO: N/A Repair Type: Non-Urgent Crossing Status: Found UCIP Comments: 06/7/2021 The record remains Non-Urgent. LS pipe inlet completely buried in dense vegetation, only top of headwall visible. Dense vegetation above WS flapgate. Limited inspection of pipe ends, recommend vegetation removal on both sides. No permit was found authorizing this encroachment. CVFPB will need to review crossing to determine owner. The UCIP inspection was completed with GEI staff, P. Espinoza. (H. Dunn ? GEI) 05/14/2014 Dense vegetation on landward toe. Also dense vegetation limits the inspector's visibility to identify signs of pipe failure (leaks) along waterward slope. Recommend removing vegetation along pipe alignment toe to conduct proper inspection of structure. Sediment buildup in pipe--recommend clearing. (O. Magana - DWR UCIP) FIELD_STRUCT_DESC: 24-inch corrugated metal gravity drainage pipe (CMP) through the levee, 9.4 feet below the crown. Flap gate on the waterside (WS) end. Brass cap No. 120 bench mark (BM) on the headwall on the landside (LS). [Additional Reference(s): DWR Levee Log, 2002, (HLM 8.49). USACE San Joaquin O&M Manual, Unit No. 601, Part No. 1, 1967, Amended in 1978, Revised 20 June 1985, (HLM 8.48)]. FS Date: 6/7/2021

Levee crown looking downstream.

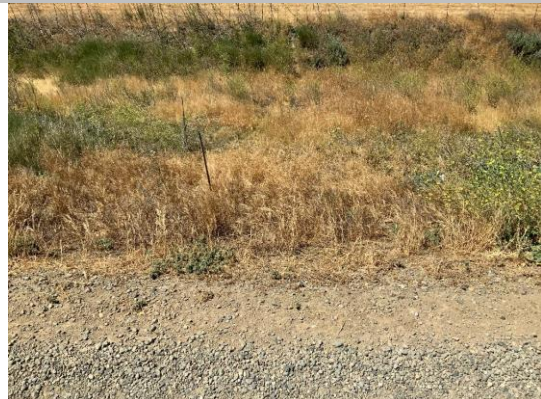
Photo 2 of 3 : UCIP_SP_2022_70954_100341.jpg

LS view: Toe and slope from crown.

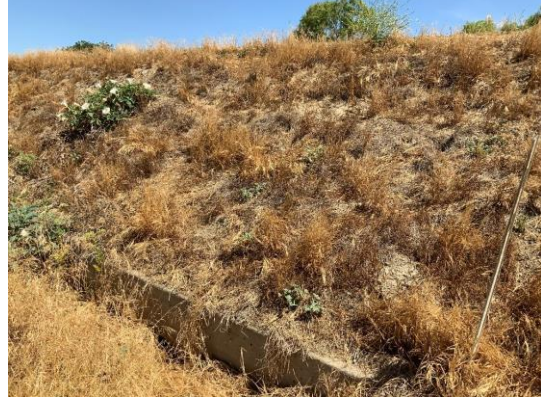
Photo 3 of 3 : UCIP_SP_2022_70954_100342.jpg

LS view: Slope from toe, top of headwall visible.

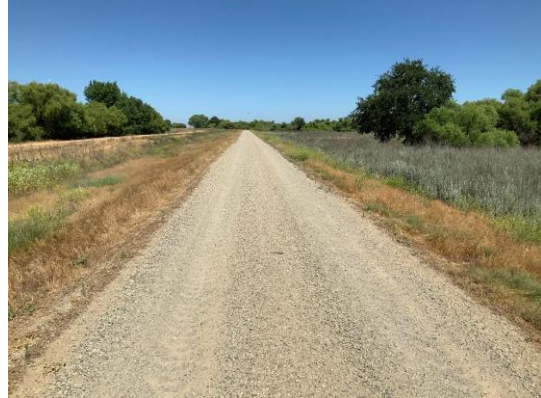
Photo 1 of 3 : UCIP_SP_2022_70955_100347.jpg

Levee crown looking downstream.

Comment Code					
Inspector Comment					
FS_ID:70955 DS_ID:19676 EP_NO: N/A Repair Type: Non-Urgent Crossing Status: Found UCIP Comments: 06/7/2021 The record remains Non-Urgent. DWR DMP internal inspection has not found pipe integrity issues. LOF of crossing is less or equal to 4.0. Recommend next video inspection in 5 years. Dense vegetation around LS pipe end, recommend removal. No permit was found authorizing this encroachment. CVFPB will need to review crossing to determine owner. The UCIP inspection was completed with GEI staff, P. Espinoza. (H. Dunn ? GEI) 05/14/2014 Dense vegetation limits the inspector's visibility to identify signs of pipe failure (leaks) along the slope. Recommend removing vegetation along pipe alignment to conduct proper inspection of structure. Burrow activity present on waterward slope. (O. Magana - DWR UCIP) FIELD_STRUCT_DESC: 24-inch corrugated metal gravity drainage pipe (CMP) through the levee, 8.8 feet below the crown. Flap gate on the waterside (WS) end. Brass cap No. 120 bench mark (BM) on the headwall on the landside (LS). [Additional Reference(s): DWR Levee Log, 2002, (HLM 8.88). USACE San Joaquin O&M Manual, Unit No. 601, Part No. 1, 1967, Amended in 1978, Revised 20 June 1985, (recorded as HLM 9.86, should be HLM 8.86)]. FS Date: 6/7/2021

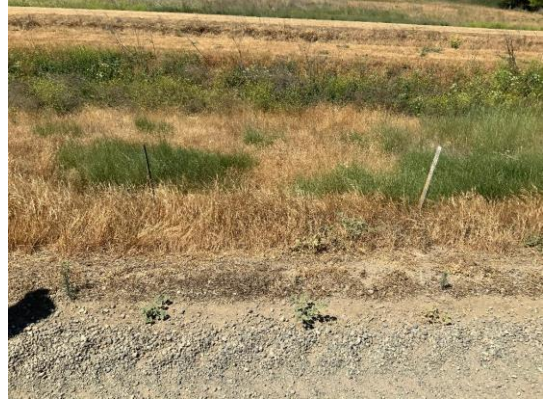
Photo 2 of 3 : UCIP_SP_2022_70955_100348.jpg

LS view: Toe from crown.

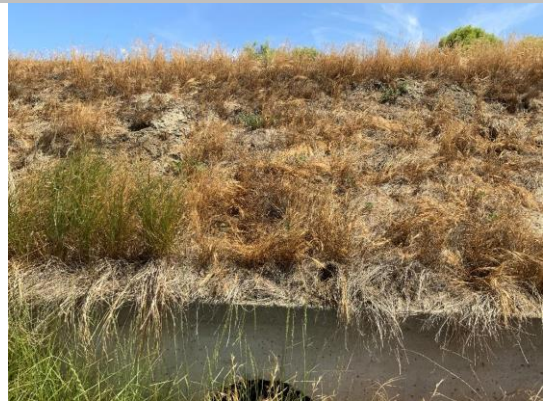
Photo 3 of 3 : UCIP_SP_2022_70955_100349.jpg

LS view: Slope above headwall from toe.

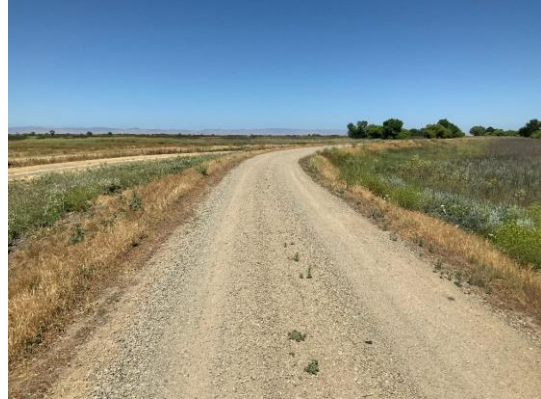
Photo 1 of 3 : UCIP_SP_2022_70956_100353.jpg

Comment Code						
Inspector Comment						
FS_ID:70956 DS_ID:19677 EP_NO: N/A Repair Type: Non-Urgent Crossing Status: Found UCIP Comments: 06/7/2021 The record remains Non-Urgent. No permit was found authorizing this encroachment. CVFPB will need to review crossing to determine owner. Minor vegetation over LS pipe inlet. The UCIP inspection was completed with GEI staff, P. Espinoza. (H. Dunn ? GEI) 05/14/201 Dense vegetation limits the inspector's visibility to identify signs of pipe failure (leaks) along the slope. Recommend removing vegetation along pipe alignment to conduct proper inspection of structure. (O. Magana - DWR UCIP) FIELD_STRUCT_DESC: 36-inch corrugated metal gravity drainage pipe (CMP) through the levee, 8.8 feet below the crown. Flap gate on the waterside (WS) end. Brass cap No. 120 bench mark (BM) on the headwall on the landside (LS). [Additional Reference(s): DWR Levee Log, 2002, (HLM 9.03). USACE San Joaquin O&M Manual, Unit No. 601, Part No. 1, 1967, Amended in 1978, Revised 20 June 1985, (HLM 9.02)]. FS Date: 6/7/2021

Levee crown looking downstream.

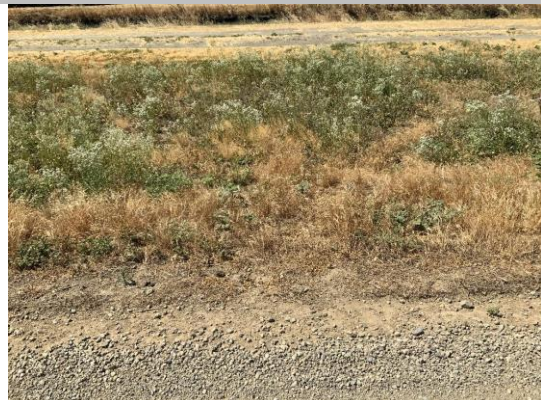
Photo 2 of 3 : UCIP_SP_2022_70956_100354.jpg

LS view: Toe from crown.

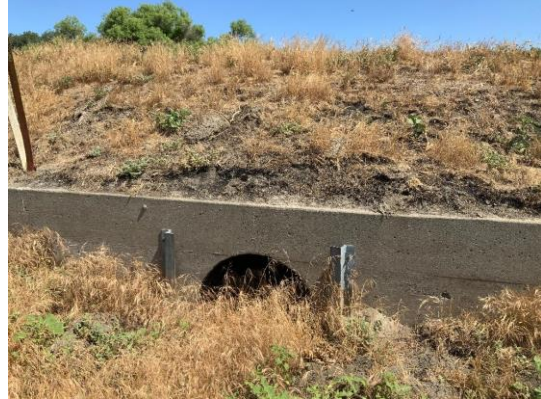
Photo 3 of 3 : UCIP_SP_2022_70956_100355.jpg

LS view: Slope and headwall at toe.

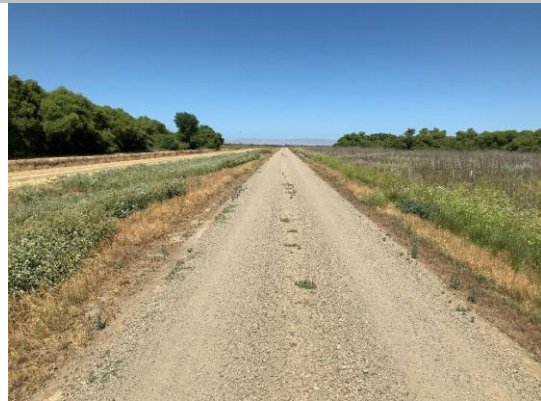
Photo 1 of 3 : UCIP_SP_2022_70957_100361.jpg

FS_ID:70957
DS_ID:19678
EP_NO: N/A
Repair Type: Non-Urgent
Crossing Status: Found
UCIP Comments: 06/7/2021 The record remains Non-Urgent. DWR DMP internal inspection has not found pipe integrity issues. LOF of crossing is less or equal to 4.0. Recommend next video inspection in 5 years. Dense vegetation over LS pipe inlet limited inspection, recommend removal. No permit was found authorizing this encroachment. CVFPB will need to review crossing to determine owner. The UCIP inspection was completed with GEI staff, P. Espinoza. (H. Dunn ? GEI) 05/14/2014 Dense vegetation limits the inspector's visibility to identify signs of pipe failure (leaks) along the slope. Recommend removing vegetation along pipe alignment to conduct proper inspection of structure. (O. Magana - DWR UCIP)
FIELD_STRUCT_DESC: 24-inch corrugated metal gravity drainage pipe (CMP) through the levee, 8.0 feet below the crown. Flap gate on the waterside (WS) end. Brass cap No. 120 bench mark (BM) on the headwall on the landside (LS). [Additional Reference(s): DWR Levee Log, 2002, (HLM 9.21). USACE San Joaquin O&M Manual, Unit No. 601, Part No. 1, 1967, Amended in 1978, Revised 20 June 1985, (HLM 9.20)].

Levee crown looking downstream.

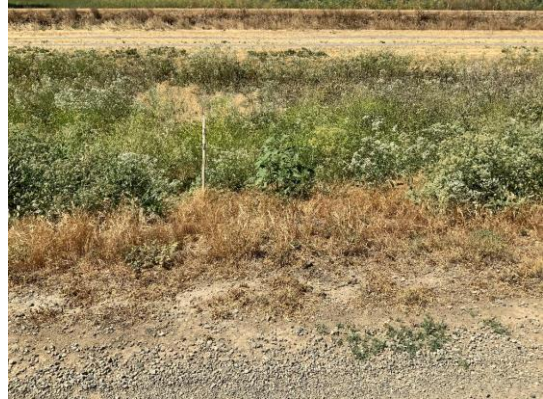
Photo 2 of 3 : UCIP_SP_2022_70957_100362.jpg

LS view: Toe from crown.

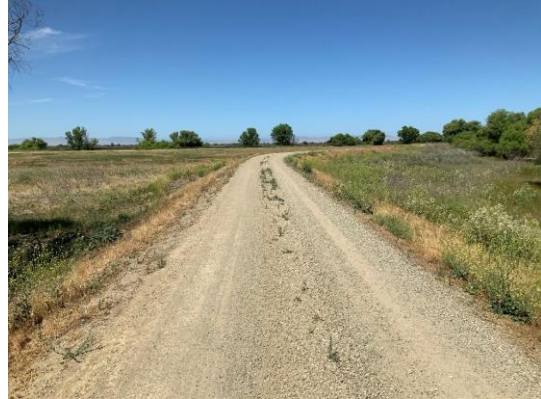
Photo 1 of 3 : UCIP_SP_2022_70958_100369.jpg

Comment Code						
Inspector Comment						
FS_ID:70958 DS_ID:19686 EP_NO: N/A Repair Type: Urgent Crossing Status: Found UCIP Comments: 06/7/2021 The record has been upgraded from Non-Urgent to Urgent. DWR DMP internal inspection has found pipe integrity issues. LOF of crossing is greater than or equal to 5.0. Crossing will be monitored until funding becomes available to address the issues. Some rusting and peeling of liner inside LS pipe inlet. No permit was found authorizing this encroachment. CVFPB will need to review crossing to determine owner. The UCIP inspection was completed with GEI staff, P. Espinoza. (H. Dunn ? GEI)05/14/2014 Dense vegetation limits the inspector's visibility to identify signs of pipe failure (leaks) along the slope. Recommend removing vegetation along pipe alignment to conduct proper inspection of structure. (O. Magana - DWR UCIP) FIELD_STRUCT_DESC: 24-inch corrugated metal gravity drainage pipe (CMP) through the levee, 9.0 feet below the crown. Flap gate on the waterside (WS) end. Brass cap No. 115 bench mark (BM) on the headwall on the landside (LS). [Additional Reference(s): DWR Levee Log, 2002, (HLM 9.47). USACE San Joaquin O&M Manual, Unit No. 601, Part No. 1, 1967, Amended in 1978, Revised 20 June 1985, (HLM 9.46)]. FS Date: 6/7/2021

Levee crown looking downstream.

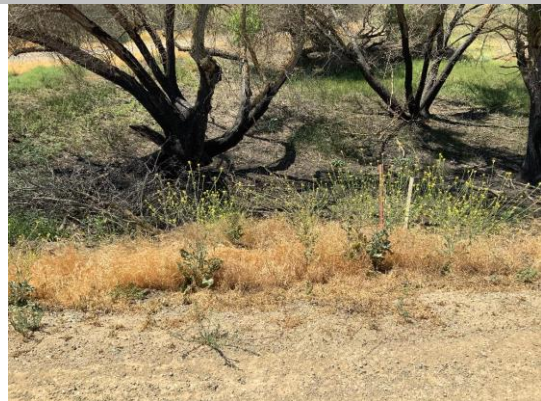
Photo 2 of 3 : UCIP_SP_2022_70958_100370.jpg

LS view: Toe from crown.

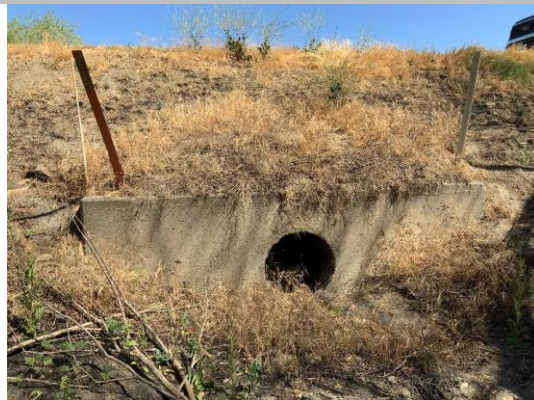
Photo 3 of 3 : UCIP_SP_2022_70958_100371.jpg

LS view: Slope and headwall at toe.

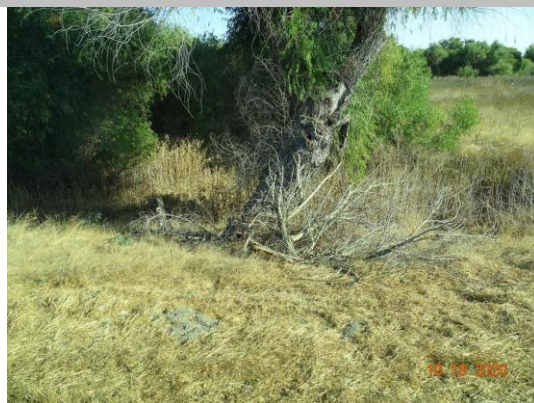
Photo 1 of 1 : SP_2022_NA0010_120_15_20220308_00003.jpg

LM Start	9.60	Rating **	M	Issue No.	15
LM End	9.60	Issue Type +	Ma	Location *	WS
Category	Earthen Levee			GPS Latitude/Longitude	
				Start	End
Item	Encroachments			37.220783 °	37.220783 °
				-120.785729 °	-120.785729 °
DWR ID	DWR_NA0010_02B_f_2020_15				
Comment Code					
TR : Tree or limb					
Inspector Comment					
Broken tree limbs on the waterside slope.

Tree limb on the waterside slope. (Fall 2020)

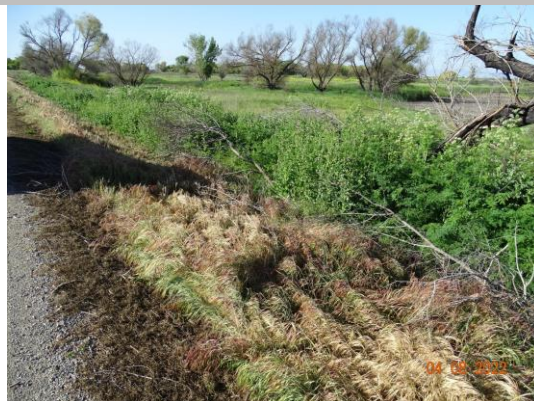
Photo 1 of 1 : SP_2022_NA0010_120_18_20220412_00051.jpg

LM Start	9.85	Rating **	M	Issue No.	18
LM End	9.85	Issue Type +	Ma	Location *	LS
Category	Earthen Levee			GPS Latitude/Longitude	
				Start	End
Item	Trim / Thin Trees			37.217702 °	37.217702 °
				-120.784130 °	-120.784130 °
DWR ID	DWR_NA0010_02B_s_2022_18				
Comment Code					
T6 : Trees / Falling Tree.					
Inspector Comment

Fallen tree branches on the landside slope. (Spring 2022)

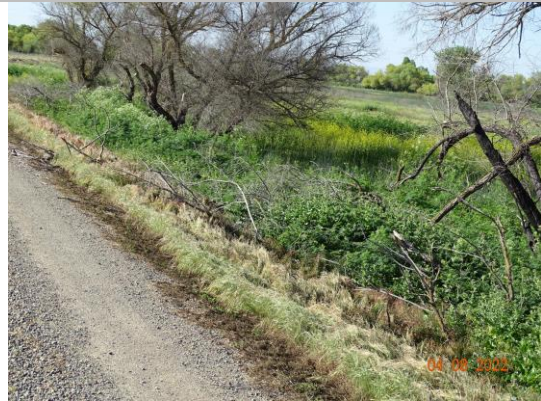
Photo 1 of 1 : SP_2022_NA0010_120_19_20220412_00052.jpg

LM Start	9.90	Rating **	M	Issue No.	19
LM End	9.90	Issue Type +	Ma	Location *	LS
Category	Earthen Levee			GPS Latitude/Longitude	
				Start	End
Item	Trim / Thin Trees			37.217010 °	37.217010 °
				-120.784018 °	-120.784018 °
DWR ID	DWR_NA0010_02B_s_2022_19				
Comment Code					
T6 : Trees / Falling Tree.					
Inspector Comment

View of tree limbs fallen on the landside toe. (Spring 2020)

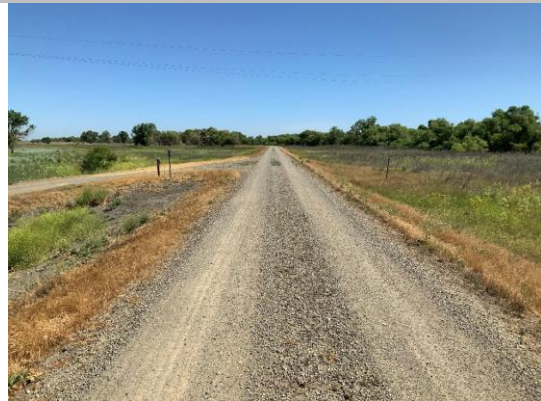
Photo 1 of 3 : UCIP_SP_2022_70959_100376.jpg

Comment Code						
Inspector Comment						
FS_ID:70959 DS_ID:19687 EP_NO: N/A Repair Type: Non-Urgent Crossing Status: Found UCIP Comments: 06/7/2021 The record remains Non-Urgent. Some sediment buildup inside LS pipe inlet. LS pipe inlet also covered by some vegetation. Recommend cleaning out sediment and removing vegetation. WS flapgate partially underwater and covered by vegetation, limited inspection of both WS and LS. No permit was found authorizing this encroachment. CVFPB will need to review crossing to determine owner. The UCIP inspection was completed with GEI staff, P. Espinoza. (H. Dunn- GEI) 05/14/2014 Dense vegetation limits the inspector's visibility to identify signs of pipe failure (leaks) along the slope. Recommend removing vegetation along pipe alignment to conduct proper inspection of structure. (O. Magana - DWR UCIP) FIELD_STRUCT_DESC: 24-inch corrugated metal gravity drainage pipe (CMP) through the levee, 11.7 feet below the crown. Flap gate on the waterside (WS) end. Brass cap No. 115 bench mark (BM) on the headwall on the landside (LS). [Additional Reference(s): DWR Levee Log, 2002, (HLM 10.13). USACE San Joaquin O&M Manual, Unit No. 601, Part No. 1, 1967, Amended in 1978, Revised 20 June 1985, (HLM 10.12)]. FS Date: 6/7/2021

Levee crown looking downstream.

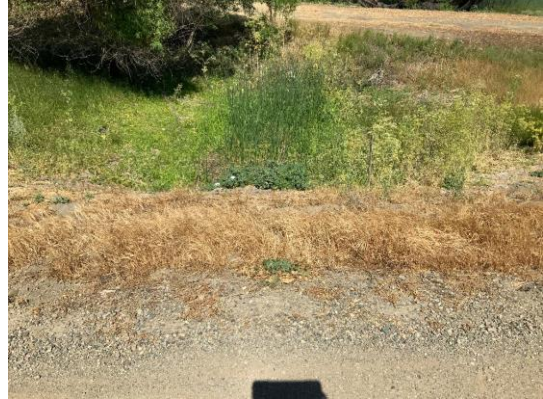
Photo 2 of 3 : UCIP_SP_2022_70959_100377.jpg

LS view: Toe from crown.

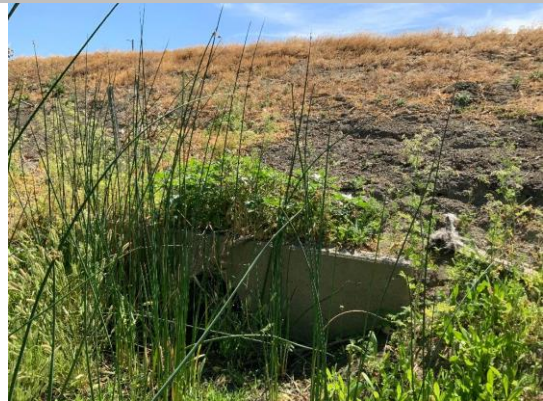
Photo 3 of 3 : UCIP_SP_2022_70959_100378.jpg

LS view: Slope and headwall from toe.

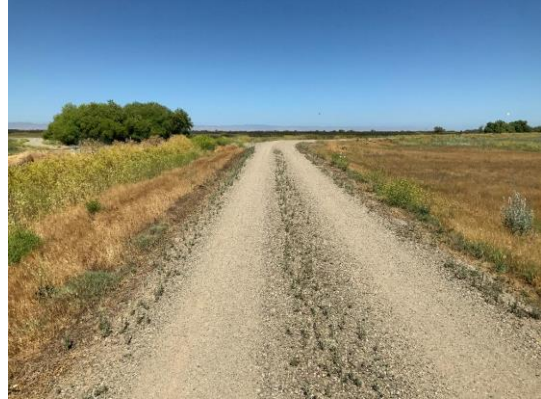
Photo 1 of 3 : UCIP_SP_2022_70960_100384.jpg

Comment Code						
Inspector Comment						
FS_ID:70960 DS_ID:19688 EP_NO: N/A Repair Type: Non-Urgent Crossing Status: Found UCIP Comments: 06/7/2021 The record remains Non-Urgent. WS end and flapgate is overgrown with dense vegetation limiting inspection, recommend removal. No permit was found authorizing this encroachment. CVFPB will need to review crossing to determine owner. The UCIP inspection was completed with GEI staff, P. Espinoza. (H. Dunn ? GEI) 05/14/2014 Dense vegetation limits the inspector's visibility to identify signs of pipe failure (leaks) along the slope. Recommend removing vegetation along pipe alignment to conduct proper inspection of structure. Sediment buildup in pipe visible on landward side--recommend clearing. (O. Magana - DWR UCIP) FIELD_STRUCT_DESC: 24-inch corrugated metal gravity drainage pipe (CMP) through the levee, 8.0 feet below the crown. Flap gate on the waterside (WS) end. Brass cap No. 115 bench mark (BM) on the headwall on the landside (LS). [Additional Reference(s): DWR Levee Log, 2002, (HLM 10.82). USACE San Joaquin O&M Manual, Unit No. 601, Part No. 1, 1967, Amended in 1978, Revised 20 June 1985, (HLM 10.81)]. FS Date: 6/7/2021

Levee crown looking downstream.

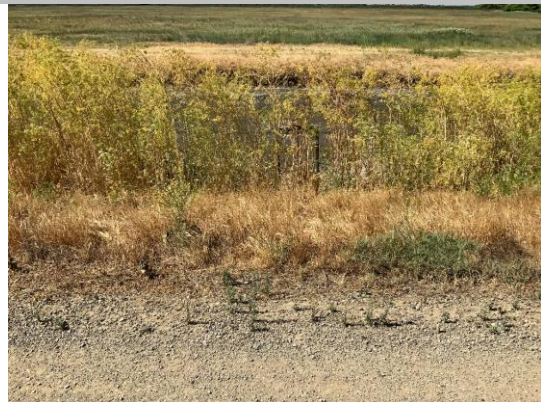
Photo 2 of 3 : UCIP_SP_2022_70960_100385.jpg

LS view: Toe from crown.

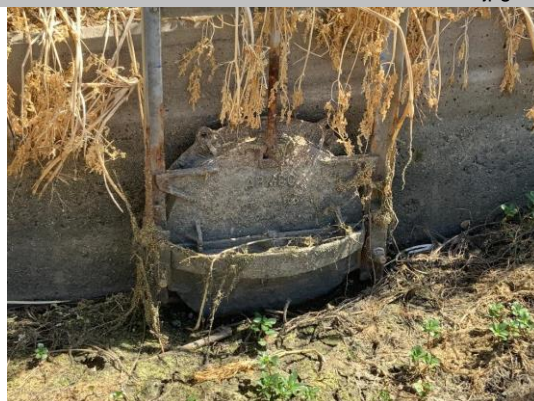
Photo 3 of 3 : UCIP_SP_2022_70960_100386.jpg

LS view: Closeup of pipe inlet and slidegate at toe.

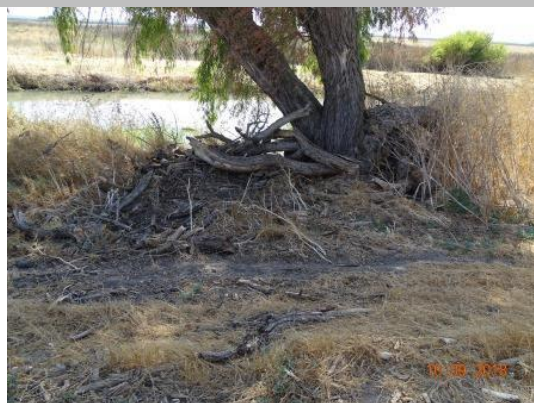
Photo 1 of 1 : SP_2022_NA0010_120_14_20220308_00002.jpg

LM Start	10.94	Rating **	M	Issue No.	14
LM End	10.94	Issue Type +	Ma	Location *	LS
Category	Earthen Levee			GPS Latitude/Longitude	
				Start	End
Item	Encroachments			37.205711 °	37.205711 °
				-120.774741 °	-120.774741 °
DWR ID	DWR_NA0010_02B_f_2015_14				
Comment Code					
PR : Prunings					
Inspector Comment					
Remove prunings from landside toe.

Prunings at landside toe. (Fall 2018)

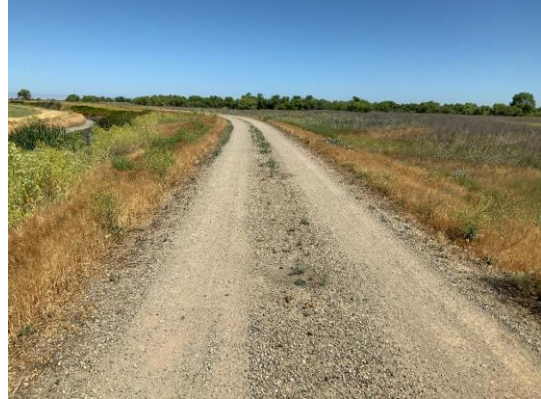
Photo 1 of 3 : UCIP_SP_2022_70961_100388.jpg

Comment Code					
Inspector Comment					
FS_ID:70961 DS_ID:19689 EP_NO: N/A Repair Type: Non-Urgent Crossing Status: Found UCIP Comments: 06/7/2021 The record remains Non-Urgent. Dense vegetation covering LS pipe inlet limiting inspection, recommend removal. No permit was found authorizing this encroachment. CVFPB will need to review crossing to determine owner. The UCIP inspection was completed with GEI staff, P. Espinoza. (H. Dunn- GEI) 05/14/201 Dense vegetation limits the inspector's visibility to identify signs of pipe failure (leaks) along the slope. Recommend removing vegetation along pipe alignment to conduct proper inspection of structure. (O. Magana - DWR UCIP) FIELD_STRUCT_DESC: 24-inch corrugated metal gravity drainage pipe (CMP) through the levee, 8.0 feet below the crown. Flap gate on the waterside (WS) end. Brass cap No. 115 bench mark (BM) on the headwall on the landside (LS). [Additional Reference(s): DWR Levee Log, 2002, (HLM 11.18). USACE San Joaquin O&M Manual, Unit No. 601, Part No. 1, 1967, Amended in 1978, Revised 20 June 1985, (HLM 11.17)]. FS Date: 6/7/2021

Levee crown looking downstream.

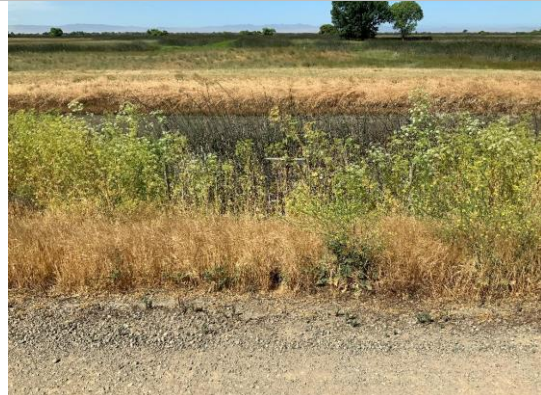
Photo 2 of 3 : UCIP_SP_2022_70961_100389.jpg

LS view: Toe from crown.

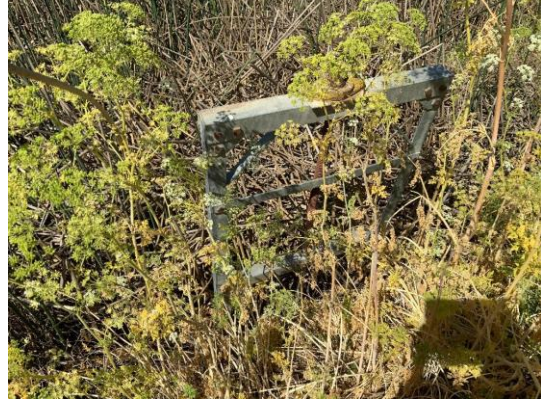
Photo 3 of 3 : UCIP_SP_2022_70961_100390.jpg

LS view: Headwall barely visible at toe, inlet covered in vegetation.
