**Flood Control Project Maintenance
Levee Inspections**

Maintenance Issue Types Only, Levee Inspection Report By Mile - Spring 2022

Lower San Joaquin Levee District

Waterway	Bank	Unit Miles	Inspection Start/End	Inspector
Unit No. 01 San Joaquin River	Right	22.52	04/05/2022 04/05/2022	Corey Fujitani

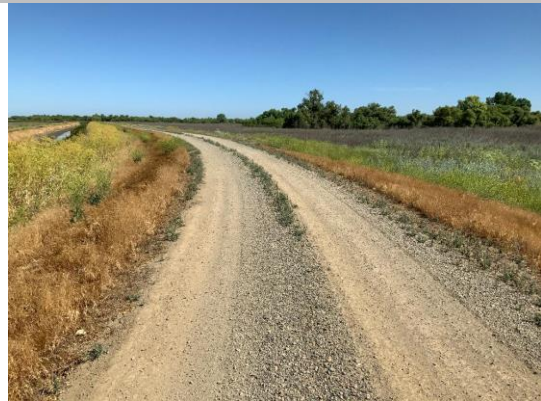
Photo 1 of 3 : UCIP_SP_2022_70962_100394.jpg

FS_ID:70962
DS_ID:19690
EP_NO: N/A
Repair Type: Non-Urgent
Crossing Status: Found
UCIP Comments: 06/7/2021 The record remains Non-Urgent. Dense vegetation over LS end, cannot see pipe inlet, recommend vegetation removal. WS flapgate has some vegetation covering it, recommend clearing. No permit was found authorizing this encroachment. CVFPB will need to review crossing to determine owner. The UCIP inspection was completed with GEI staff, P. Espinoza. (H. Dunn ? GEI)

05/14/2014 Dense vegetation limits the inspector's visibility to identify signs of pipe failure (leaks) along the slope. Recommend removing vegetation along pipe alignment to conduct proper inspection of structure. (O. Magana - DWR UCIP)

Levee crown looking downstream.

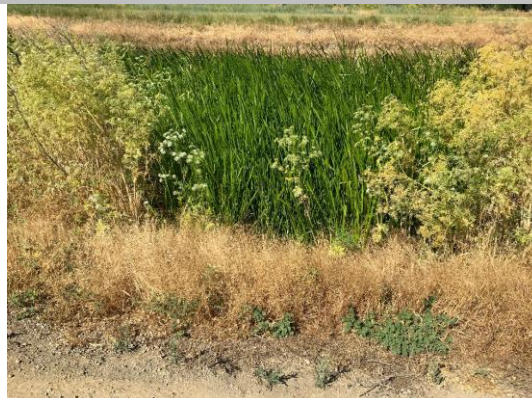
Photo 2 of 3 : UCIP_SP_2022_70962_100395.jpg

LS view: Toe from crown, dense vegetation, no pipe visible.

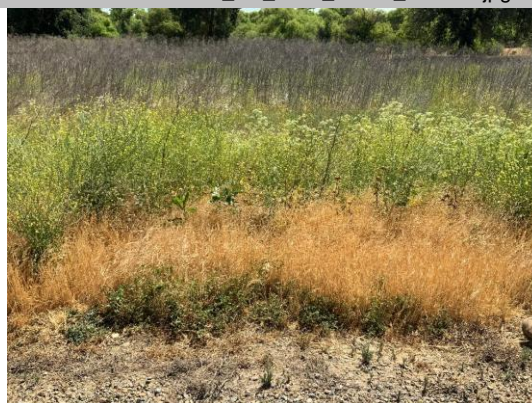
Photo 3 of 3 : UCIP_SP_2022_70962_100396.jpg

WS view: Toe from crown.

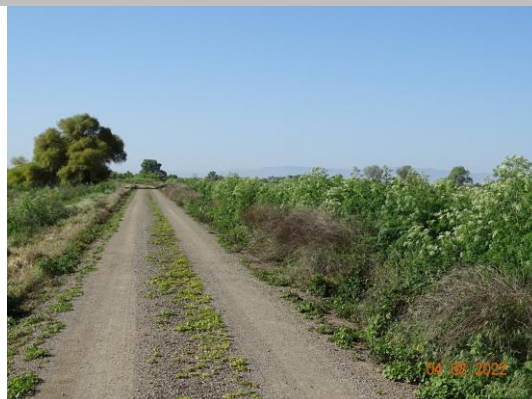
Photo 1 of 1 : SP_2022_NA0010_120_20_20220412_00053.jpg

LM Start	11.43	Rating **	U	Issue No.	20
LM End	11.67	Issue Type +	Ma	Location *	LS
Category	Earthen Levee			GPS Latitude/Longitude	
				Start	End
Item	Vegetation			37.201272 °	37.198031 °
				-120.768446 °	-120.768223 °
DWR ID	DWR_NA0010_02B_s_2022_20				
Comment Code					
V1 : Control annual grass and weeds on the levee slopes and easements.					
Inspector Comment

View of vegetation growing on the landside slope. (Spring 2022)

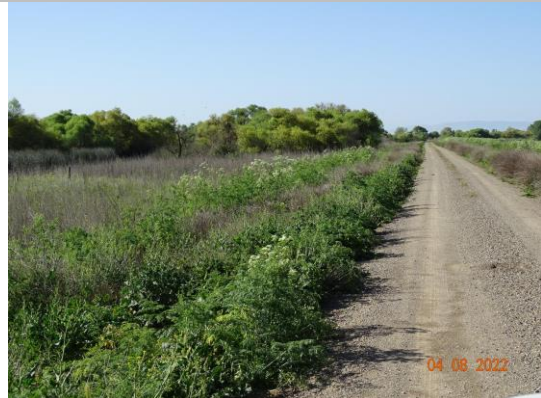
Photo 1 of 1 : SP_2022_NA0010_120_23_20220412_00054.jpg

LM Start	12.09	Rating **	U	Issue No.	23
LM End	12.17	Issue Type +	Ma	Location *	WS
Category	Earthen Levee			GPS Latitude/Longitude	
				Start	End
Item	Vegetation			37.193218 °	37.191982 °
				-120.763943 °	-120.764382 °
DWR ID	DWR_NA0010_02B_s_2022_23				
Comment Code					
V1 : Control annual grass and weeds on the levee slopes and easements.					
Inspector Comment

Looking upstream along the waterside slope at dense vegetation. (Spring 2022)

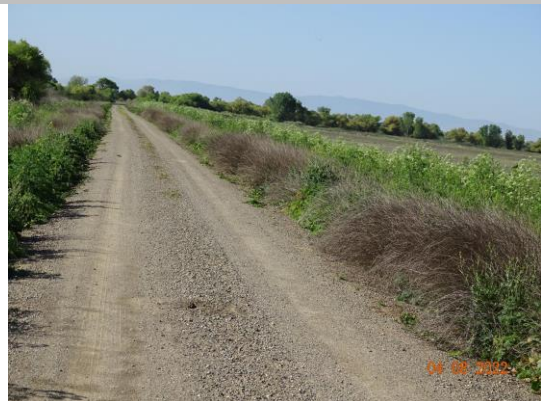
Photo 1 of 1 : SP_2022_NA0010_120_21_20220412_00055.jpg

LM Start	12.09	Rating **	U	Issue No.	21
LM End	13.75	Issue Type +	Ma	Location *	LS
Category	Earthen Levee			GPS Latitude/Longitude	
				Start	End
Item	Vegetation			37.193218 °	37.172226 °
				-120.763943 °	-120.761194 °
DWR ID	DWR_NA0010_02B_s_2022_21				
Comment Code					
V1 : Control annual grass and weeds on the levee slopes and easements.					
Inspector Comment

View of heavy vegetation on the landside slope. (Spring 2022)

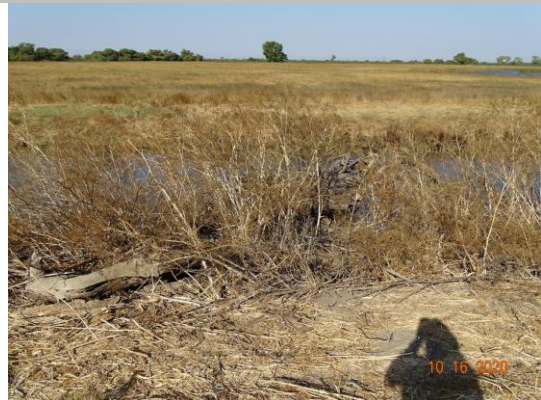
Photo 1 of 1 : SP_2022_NA0010_120_1_20220308_00001.jpg

LM Start	12.21	Rating **	M	Issue No.	1
LM End	12.21	Issue Type +	Ma	Location *	LS
Category	Earthen Levee			GPS Latitude/Longitude	
				Start	End
Item	Encroachments			37.191528 °	37.191528 °
				-120.764541 °	-120.764541 °
DWR ID	DWR_NA0010_02B_f_2014_1				
Comment Code					
TR : Tree or limb					
Inspector Comment					
Fallen tree limbs are located on the landside slope.

Fallen tree on the landside slope. (Fall 2020)

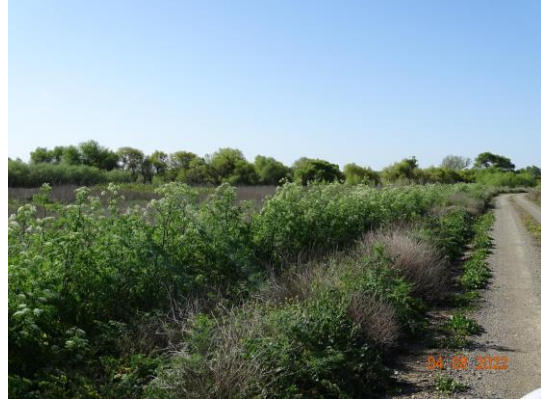
Photo 1 of 1 : SP_2022_NA0010_120_24_20220412_00056.jpg

LM Start	12.46	Rating **	U	Issue No.	24
LM End	13.75	Issue Type +	Ma	Location *	WS
Category	Earthen Levee			GPS Latitude/Longitude	
				Start	End
Item	Vegetation			37.188132 °	37.172226 °
				-120.766132 °	-120.761194 °
DWR ID	DWR_NA0010_02B_s_2022_24				
Comment Code					
V1 : Control annual grass and weeds on the levee slopes and easements.					
Inspector Comment

View of the waterside slope looking upstream. (Spring 2022)

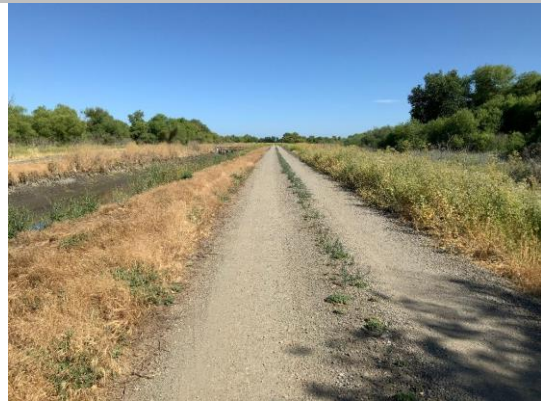
Photo 1 of 3 : UCIP_SP_2022_70963_100400.jpg

Comment Code						
Inspector Comment						
FS_ID:70963 DS_ID:19663 EP_NO: N/A Repair Type: Non-Urgent Crossing Status: Found UCIP Comments: 06/7/2021 The record remains Non-Urgent. Sediment buildup inside LS pipe inlet, recommend cleaning out. Dense vegetation over WS end limited inspection, recommend removal. No permit was found authorizing this encroachment. CVFPB will need to review crossing to determine owner. The UCIP inspection was completed with GEI staff, P. Espinoza. (H. Dunn - GEI) 05/14/201 Dense vegetation limits the inspector's visibility to identify signs of pipe failure (leaks) along the slope. Recommend removing vegetation along pipe alignment to conduct proper inspection of structure. Sediment buildup in pipe--recommend clearing. (O. Magana - DWR UCIP) FIELD_STRUCT_DESC: 24-inch corrugated metal gravity drainage pipe (CMP) through the levee, 6.5 feet below the crown. Slide gate in a pipe riser unit on the waterside (WS) slope. [Additional Reference(s): DWR Levee Log, 2002, (HLM 13.23). USACE San Joaquin O&M Manual, Unit No. 601, Part No. 1, 1967, Amended in 1978, Revised 20 June 1985, (HLM 13.22)]. FS Date: 6/7/2021

Levee crown looking downstream.

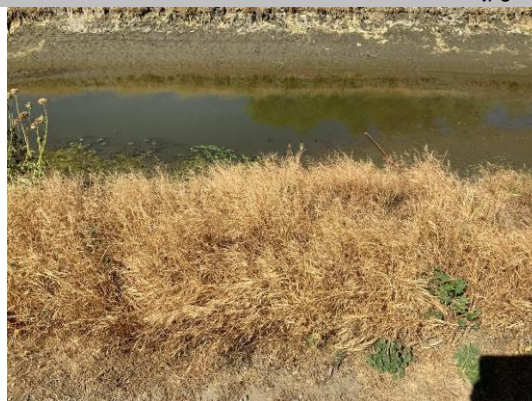
Photo 2 of 3 : UCIP_SP_2022_70963_100402.jpg

LS view: Toe from crown.

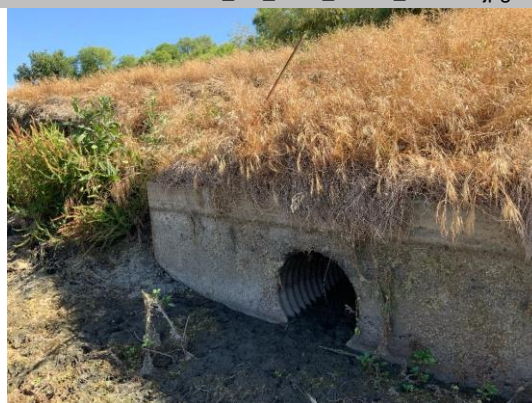
Photo 3 of 3 : UCIP_SP_2022_70963_100403.jpg

LS view: Slope, headwall, and pipe inlet at toe.

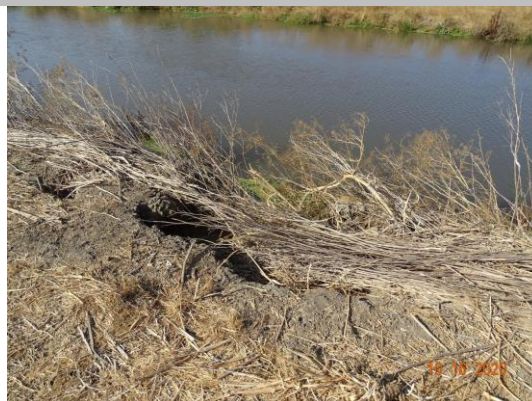
Photo 1 of 1 : SP_2022_NA0010_120_25_20220308_00011.jpg

LM Start	13.72	Rating **	M	Issue No.	25
LM End	13.72	Issue Type +	Ma	Location *	LS
Category	Earthen Levee			GPS Latitude/Longitude	
				Start	End
Item	Erosion / Bank Caving			37.172648 °	37.172648 °
				-120.761157 °	-120.761157 °
DWR ID	DWR_NA0010_02B_f_2018_25				
Comment Code					
E1 : Note and monitor erosion site.					
Inspector Comment					
Erosion is occurring into the landside bank.

View of erosion pocket in the landside slope. (Fall 2020)

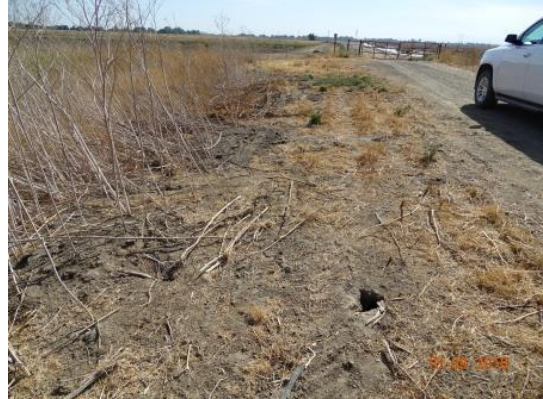
Photo 1 of 1 : SP_2022_NA0010_120_22_20220308_00008.jpg

LM Start	13.73	Rating **	M	Issue No.	22
LM End	13.73	Issue Type +	Ma	Location *	WS
Category	Earthen Levee			GPS Latitude/Longitude	
				Start	End
Item	Animal Control			37.172387 °	37.172387 °
				-120.761190 °	-120.761190 °
DWR ID	DWR_NA0010_02B_f_2018_22				
Comment Code					
A1 : Exterminate rodents and backfill and compact or grout burrows.					
Inspector Comment					
There are several rodent burrows observed at this location.

View of waterside slope looking upstream. (Fall 2018)

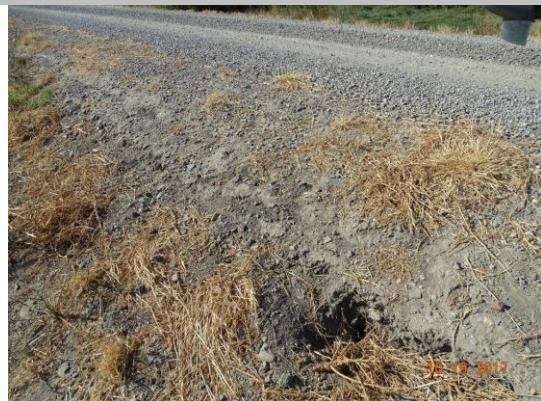
Photo 1 of 1 : SP_2022_NA0010_121_67_20220308_00008.jpg

LM Start	0.19	Rating **	M	Issue No.	67
LM End	0.19	Issue Type +	Ma	Location *	LS
Category	Earthen Levee			GPS Latitude/Longitude	
				Start	End
Item	Animal Control			37.109013 °	37.109013 °
				-120.587799 °	-120.587799 °
DWR ID	DWR_NA0010_03_s_2015_67				
Comment Code					
A3 : No rodents visible, but rodent burrows visible; need to backfill and compact or grout burrows.					
Inspector Comment					
Rodent holes are noted on the landside slope.

Looking southwest at the landside shoulder.

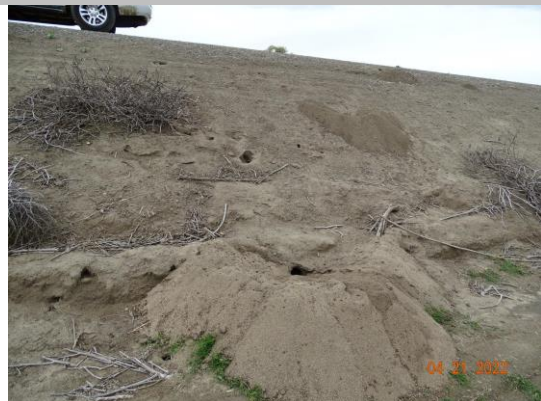
Photo 1 of 1 : SP_2022_NA0010_121_11_20220425_00021.jpg

LM Start	0.31	Rating **	U	Issue No.	11
LM End	0.31	Issue Type +	Ma	Location *	LS
Category	Earthen Levee			GPS Latitude/Longitude	
				Start	End
Item	Animal Control			37.107440 °	37.107440 °
				-120.587005 °	-120.587005 °
DWR ID	DWR_NA0010_03_s_2022_11				
Comment Code					
A3 : No rodents visible, but rodent burrows visible; need to backfill and compact or grout burrows.					
Inspector Comment					
Large amount of material displaced on the landside toe.

View of several rodent holes with large amounts of material displaced.
(Spring 2022)

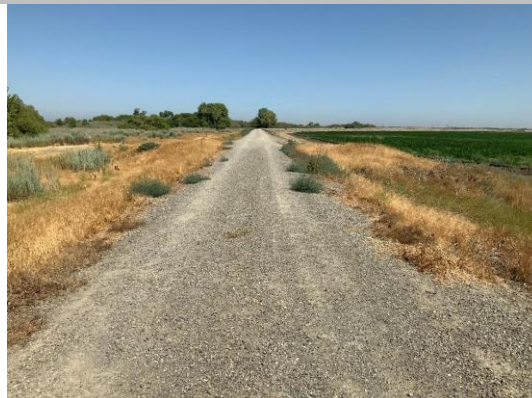
Photo 1 of 3 : UCIP_SP_2022_70965_101344.jpg

Comment Code						
Inspector Comment						
FS_ID:70965 DS_ID:19691 EP_NO: N/A Repair Type: Non-Urgent Crossing Status: Found UCIP Comments: 07/12/2021 The record remains Non-Urgent. Dense vegetation over LS pipe inlet, headwall just barely visible, recommend removal. No permit was found authorizing this encroachment. CVFPB will need to review crossing to determine owner. The UCIP inspection was completed with GEI staff, P. Espinoza. (H. Dunn ? GEI)						
04/17/2014 Need to contact owner. Recommend removing tall grass on landward slope and clearing sediment build up inside pipe. (O. Magana - DWR UCIP) FIELD_STRUCT_DESC: 24-inch corrugated metal gravity drainage pipe (CMP) through the levee, 11.3 feet below the crown. Flap gate on the waterside (WS) end. [Additional Reference(s): DWR Levee Log, 2002, (HLM 0.43). USACE San Joaquin O&M Manual, Unit No. 601, Part No. 1, 1967, Amended in 1978, Revised 20 June 1985, (HLM 0.43). DWR As-Built Specification No. 62-03, Sheet No. 10, 18 June 1962, (HLM 0.43)]. FS Date: 7/12/2021

Levee crown looking upstream.

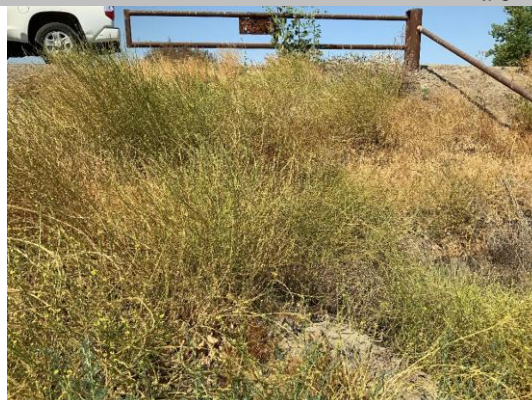
Photo 2 of 3 : UCIP_SP_2022_70965_101343.jpg

LS view: Slope from toe.

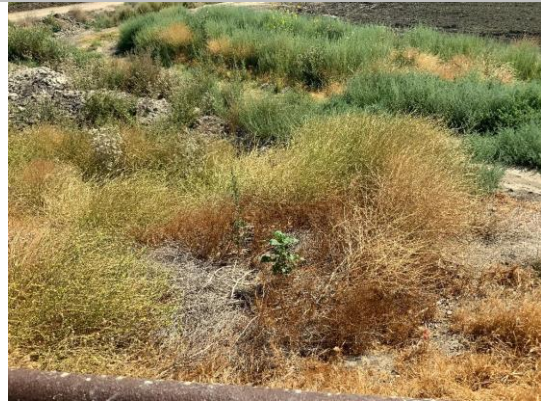
Photo 3 of 3 : UCIP_SP_2022_70965_101341.jpg

LS view: Toe from crown.

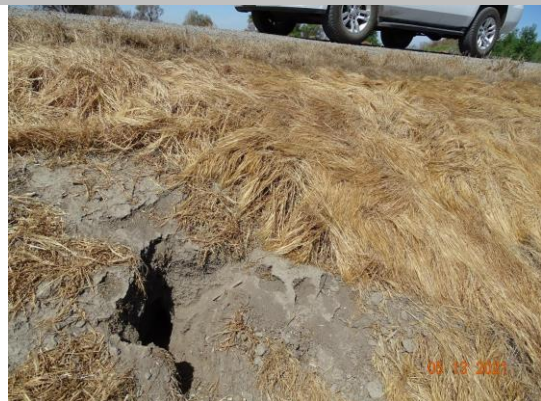
Photo 1 of 1 : SP_2022_NA0010_121_10_20220308_00005.jpg

LM Start	0.57	Rating **	U	Issue No.	10
LM End	0.57	Issue Type +	Ma	Location *	LS
Category	Earthen Levee			GPS Latitude/Longitude	
				Start	End
Item	Animal Control			37.104343 °	37.104343 °
				-120.584348 °	-120.584348 °
DWR ID	DWR_NA0010_03_s_2021_10				
Comment Code					
A3 : No rodents visible, but rodent burrows visible; need to backfill and compact or grout burrows.					
Inspector Comment

Several large rodent burrows observed at this location. (Spring 2021)

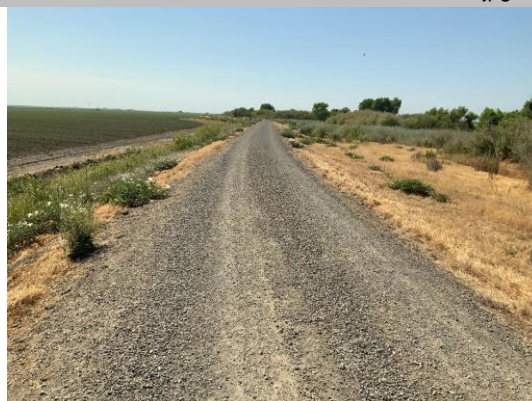
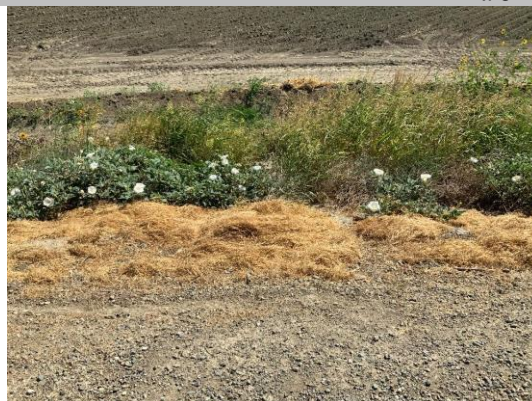
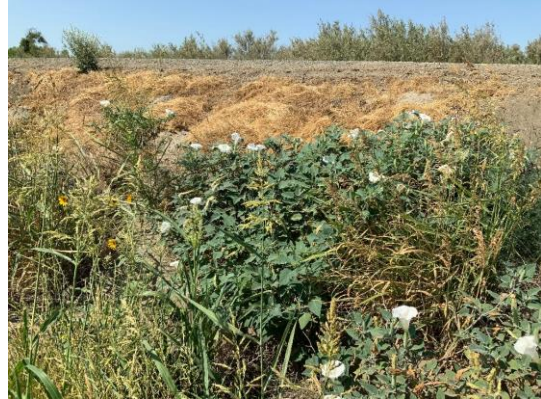
Photo 1 of 3 : UCIP_SP_2022_70966_101348.jpg

Comment Code						
Inspector Comment						
FS_ID:70966 DS_ID:19692 EP_NO: N/A Repair Type: Non-Urgent Crossing Status: Found UCIP Comments: 07/12/2021 The record has been upgraded from No Action Needed to Non-Urgent. Dense vegetation over LS pipe inlet, headwall barely visible. Minor vegetation on WS, recommend removal on both ends. No permit was found authorizing this encroachment. CVFPB will need to review crossing to determine owner. The UCIP inspection was completed with GEI staff, P. Espinoza. (H. Dunn ? GEI) FIELD_STRUCT_DESC: 24-inch corrugated metal gravity drainage pipe (CMP) through the levee, 9.3 feet below the crown. Flap gate on the waterside (WS) end. [Additional Reference(s): DWR Levee Log, 2002, (HLM 0.78). USACE San Joaquin O&M Manual, Unit No. 601, Part No. 1, 1967, Amended in 1978, Revised 20 June 1985, (HLM 0.77). DWR As-Built Specification No. 62-03, Sheet No. 10, 18 June 1962, (HLM 0.77)]. FS Date: 7/12/2021

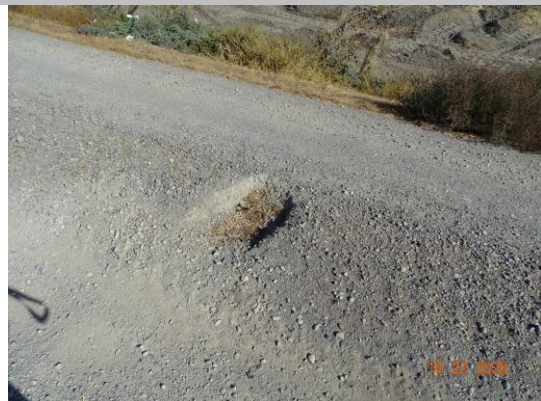
Photo 1 of 1 : SP_2022_NA0010_121_8_20220308_00004.jpg

LM Start	0.86	Rating **	M	Issue No.	8
LM End	0.86	Issue Type +	Ma	Location *	CR
Category	Earthen Levee			GPS Latitude/Longitude	
				Start	End
Item	Animal Control			37.101821 °	37.101821 °
				-120.580358 °	-120.580358 °
DWR ID	DWR_NA0010_03_f _ 2020_8				
Comment Code					
A3 : No rodents visible, but rodent burrows visible; need to backfill and compact or grout burrows.					
Inspector Comment

Depression in the levee crown from rodent activity. (Fall 2020)

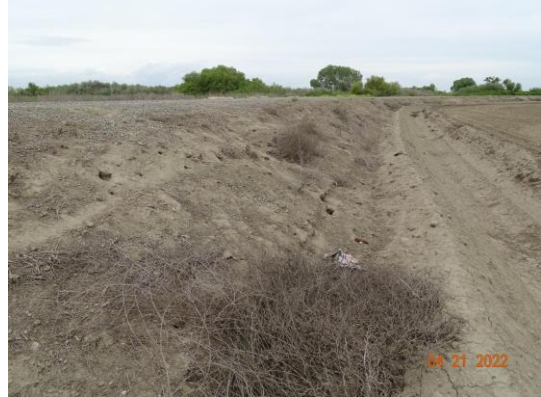
Photo 1 of 1 : SP_2022_NA0010_121_12_20220425_00022.jpg

LM Start	1.70	Rating **	M	Issue No.	12
LM End	1.78	Issue Type +	Ma	Location *	LS
Category	Earthen Levee			GPS Latitude/Longitude	
				Start	End
Item	Animal Control			37.092231 °	37.091302 °
				-120.572337 °	-120.571632 °
DWR ID	DWR_NA0010_03_f _ 2020_12				
Comment Code					
A1 : Exterminate rodents and backfill and compact or grout burrows.					
Inspector Comment

View of several animal holes in the landside slope. (Spring 2022)

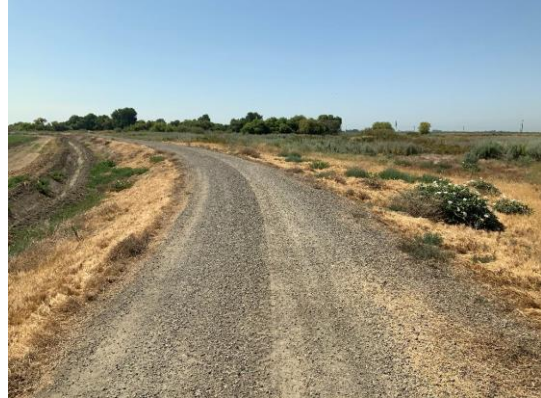
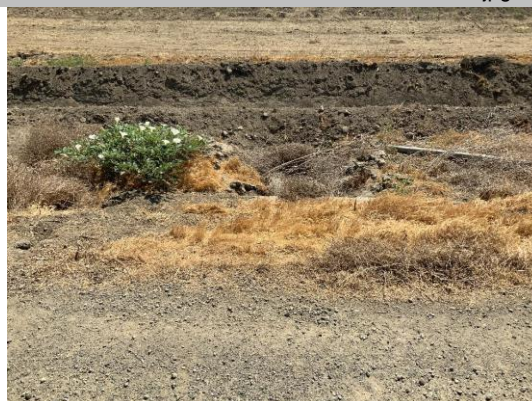
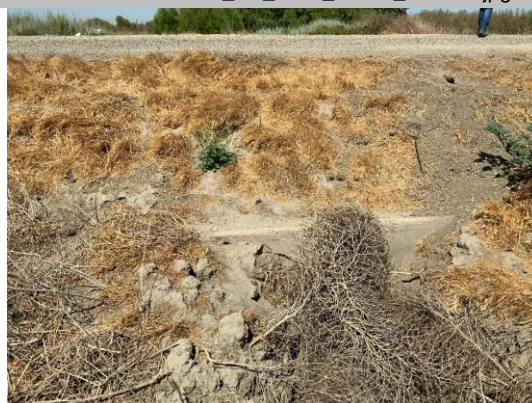
Photo 1 of 3 : UCIP_SP_2022_70967_101357.jpg

Comment Code					
Inspector Comment					
FS_ID:70967 DS_ID:19693 EP_NO: N/A Repair Type: Non-Urgent Crossing Status: Found UCIP Comments: 07/12/2021 The record remains Non-Urgent. There is dense vegetation over LS pipe inlet and WS flapgate, recommend removal. No permit was found authorizing this encroachment. CVFPB will need to review crossing to determine owner. The UCIP inspection was completed with GEI staff, P. Espinoza. (H. Dunn ? GEI) 04/17/2014 Sediment buildup in pipe visible from landward side-- recommend clearing. (O. Magana - DWR UCIP) FIELD_STRUCT_DESC: 24-inch corrugated metal gravity drainage pipe (CMP) through the levee, 6.8 feet below the crown. Flap gate on the waterside (WS) end. [Additional Reference(s): DWR Levee Log, 2002, (HLM 1.73). USACE San Joaquin O&M Manual, Unit No. 601, Part No. 1, 1967, Amended in 1978, Revised 20 June 1985, (HLM 1.72). DWR As-Built Specification No. 62-03, Sheet No. 11, 18 June 1962, (HLM 1.72)]. FS Date: 7/12/2021

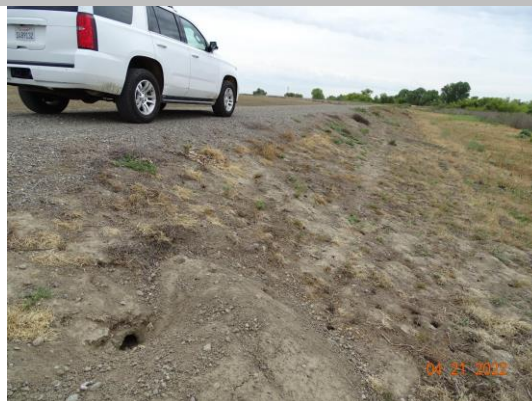
Photo 1 of 1 : SP_2022_NA0010_121_17_20220425_00023.jpg

LM Start	1.77	Rating **	M	Issue No.	17
LM End	1.77	Issue Type +	Ma	Location *	WS
Category	Earthen Levee			GPS Latitude/Longitude	
				Start	End
Item	Animal Control			37.091446 °	37.091446 °
				-120.571777 °	-120.571777 °
DWR ID	DWR_NA0010_03_s_2022_17				
Comment Code					
A1 : Exterminate rodents and backfill and compact or grout burrows.					
Inspector Comment

Multiple rodent burrows observed on the waterside slope. (Spring 2022)

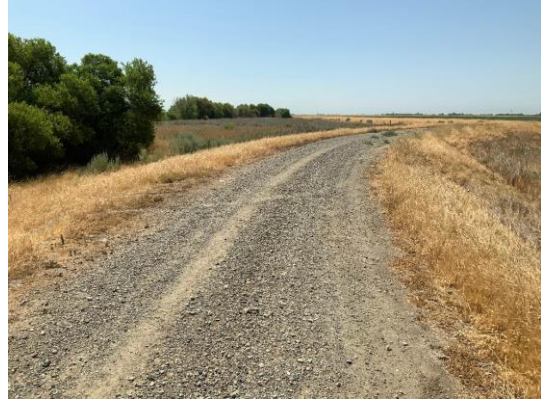
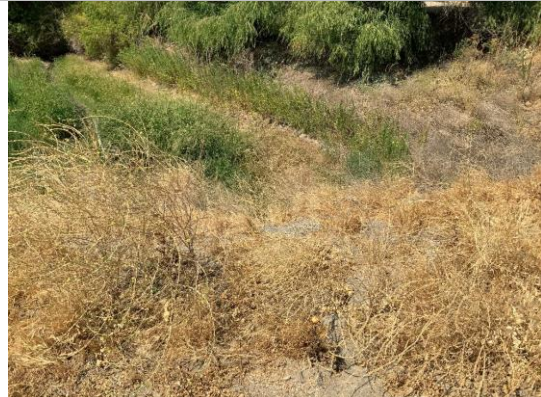
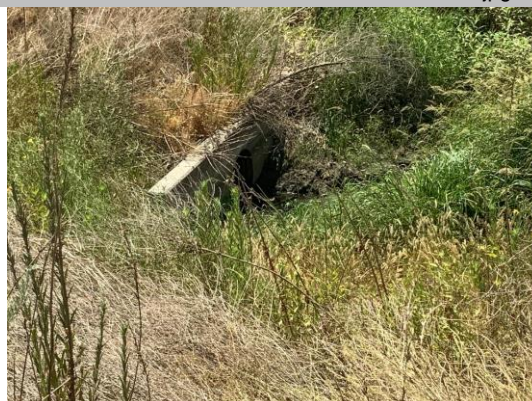
Photo 1 of 3 : UCIP_SP_2022_70974_101404.jpg

Comment Code						
Inspector Comment						
FS_ID:70974 DS_ID:19695 EP_NO: N/A Repair Type: Non-Urgent Crossing Status: Found UCIP Comments: 07/12/2021 The record remains Non-Urgent. WS flapgate is underwater and covered by vegetation. LS inlet also covered by vegetation, recommend removal on both ends. No permit was found authorizing this encroachment. CVFPB will need to review crossing to determine owner. The UCIP inspection was completed with GEI staff, P. Espinoza. (H. Dunn ? GEI) 04/17/2014 Sediment and debris blocking concrete headwall located on waterward side. During inspection water was flowing from landward side to waterward side. Recommend removing sediment to confirm condition of flap gate and pipe. (O. Magana - DWR UCIP) FIELD_STRUCT_DESC: 36-inch corrugated metal gravity drainage pipe (CMP) through the levee, 18.0 feet below the crown. Flap gate on the waterside (WS) end. Concrete headwall on each end. [Additional Reference(s): DWR Levee Log, 2002, (HLM 0.24). USACE San Joaquin O&M Manual, Unit No. 601, Part No. 1, 1967, Amended in 1978, Revised 20 June 1985, (HLM 0.27)]. FS Date: 7/12/2021

LS view: Pipe inlet with water in it at toe.

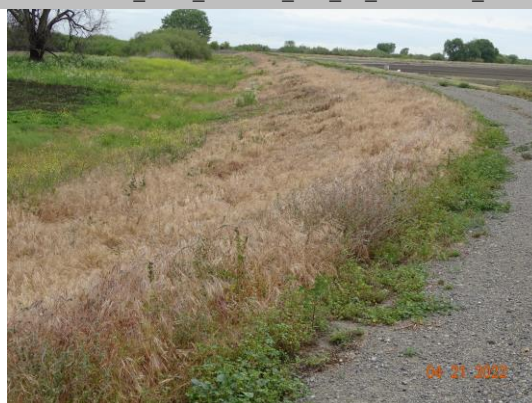
Photo 1 of 1 : SP_2022_NA0010_122_11_20220425_00025.jpg

LM Start	0.36	Rating **	M	Issue No.	11
LM End	1.35	Issue Type +	Ma	Location *	WS
Category	Earthen Levee			GPS Latitude/Longitude	
				Start	End
Item	Vegetation			37.108376 °	37.098382 °
				-120.590413 °	-120.578273 °
DWR ID	DWR_NA0010_04_s_2022_11				
Comment Code					
V1 : Control annual grass and weeds on the levee slopes and easements.					
Inspector Comment

Looking upstream along the waterside slope. (Spring 2022)

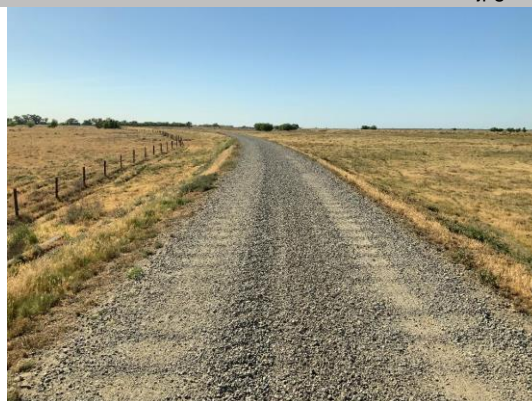
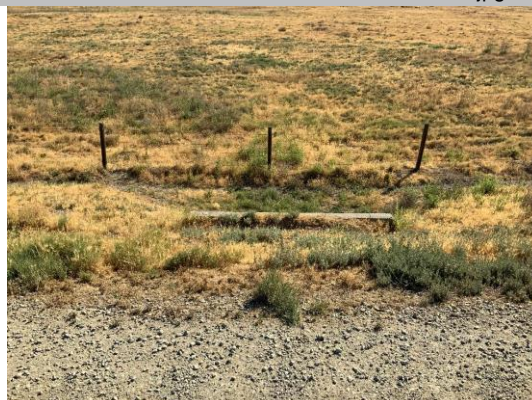
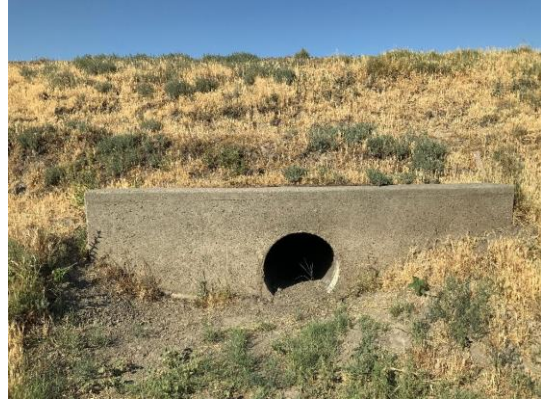
Photo 1 of 3 : UCIP_SP_2022_70983_99634.jpg

Comment Code					
Inspector Comment					
FS_ID:70983 DS_ID:19756 EP_NO: N/A Repair Type: Non-Urgent Crossing Status: Found UCIP Comments: 06/1/2021 Record remains Non-Urgent. DWR DMP internal inspection has not found pipe integrity issues. LOF of crossing is less or equal to 4.0. Recommend next video inspection in 5 years. Some soil sloughing/erosion on the WS slope. No permit was found authorizing this encroachment. CVFPB will need to review crossing to determine owner. The UCIP inspection was completed with GEI staff, P. Espinoza. (H. Dunn ? GEI) 04/09/2014 Debris blocking landward headwall--recommend clearing. (W. Wylie - DWR UCIP) FIELD_STRUCT_DESC: 24-inch corrugated metal gravity drainage pipe (CMP) through the levee, 8.6 feet below the crown. Concrete U-shaped headwall and flap gate on the waterside (WS) end. Concrete headwall on the landside (LS) end. [Additional Reference(s): DWR Levee Log, 2002, (HLM 0.07). USACE San Joaquin O&M Manual, Unit No. 601, Part No. 1, 1967, Amended in 1978, Revised 20 June 1985, (HLM 0.07)]. FS Date: 6/1/2021

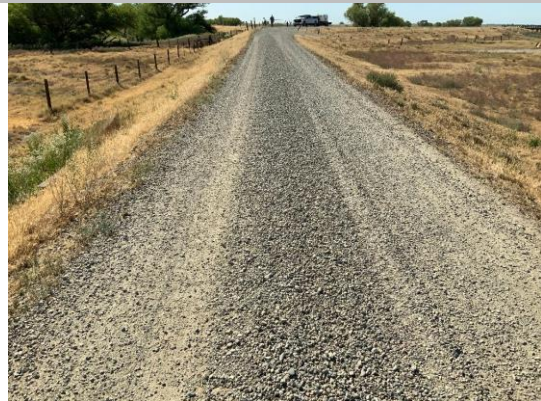
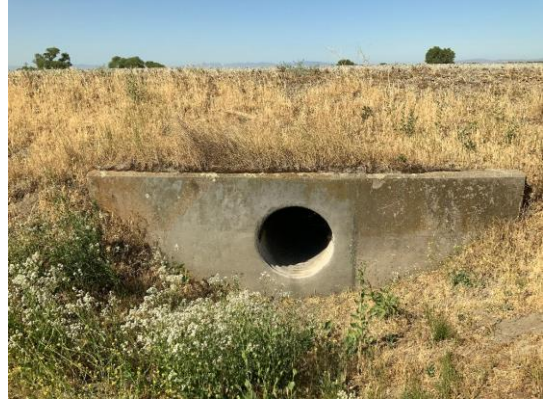
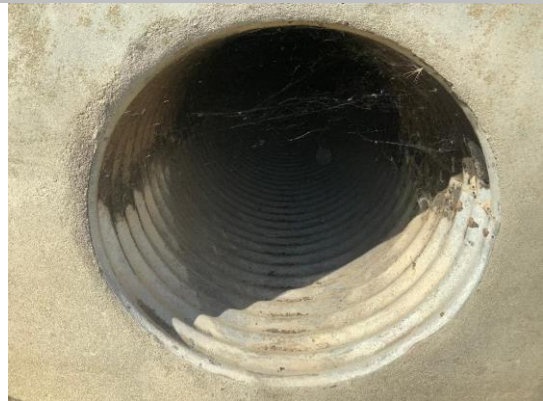
Photo 1 of 3 : UCIP_SP_2022_70986_99654.jpg

FS_ID:70986
DS_ID:19757
EP_NO: N/A
Repair Type: Non-Urgent
Crossing Status: Found
UCIP Comments: 06/1/2021 Record remains Non-Urgent. DWR DMP internal inspection has found pipe integrity issues. LOF of crossing is greater than or equal to 4.1 and less than 5. Crossing will be monitored until funding becomes available for rehabilitation. No permit was found authorizing this encroachment. CVFPB will need to review crossing to determine owner. The UCIP inspection was completed with GEI staff, P. Espinoza. (H. Dunn ? GEI) 04/09/2014 Excess debris on landward headwall--recommend clearing. (W. Wylie - DWR UCIP)
FIELD_STRUCT_DESC: 30-inch corrugated metal gravity drainage pipe (CMP) through the levee, 7.5 feet below the crown. Flap gate on the waterside (WS) end. Concrete headwall on the landside (LS) end. Concrete U-shaped headwall on the WS end. [Additional Reference(s): DWR Levee Log, 2002, (HLM 0.58). USACE San Joaquin O&M Manual, Unit No. 601, Part No. 1, 1967, Amended in 1978, Revised 20 June 1985, (HLM 0.59). DWR As-Built Specification No. 63-25, Sheet No. 4, 9 May 1963, (Station -2+15)].

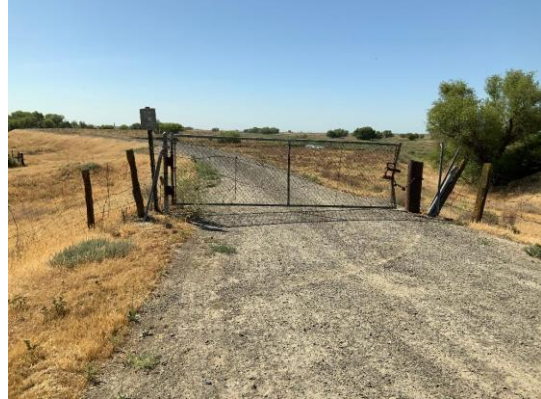
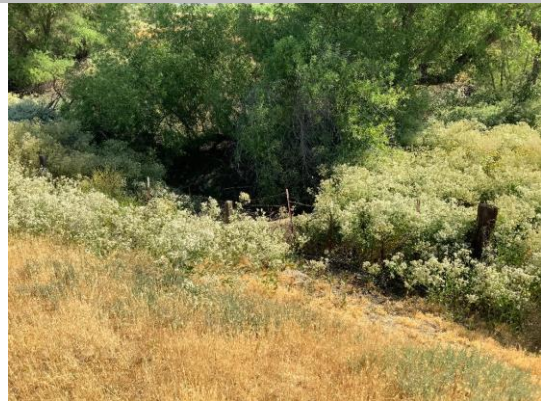
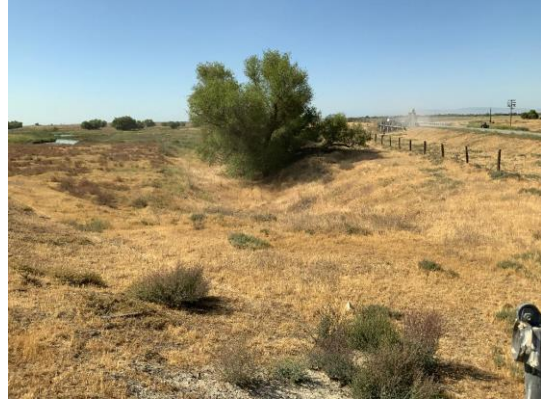
Photo 1 of 3 : UCIP_SP_2022_70987_99659.jpg

FS_ID:70987
DS_ID:19758
EP_NO: N/A
Repair Type: Urgent
Crossing Status: Found
UCIP Comments: 06/1/2021 Record has been upgraded from Non-Urgent to Urgent. DWR DMP internal inspection has found pipe integrity issues. LOF of crossing is greater than or equal to 5 and less than 6. Crossing will be monitored until funding becomes available to address the issues. No closeup inspection of LS pipe end due to dense vegetation and barbed wire. No permit was found authorizing this encroachment. CVFPB will need to review crossing to determine owner. The UCIP inspection was completed with GEI staff, P. Espinoza. (H. Dunn ? GEI)04/09/2014 Dense vegetation limits the inspector's visibility to identify signs of pipe failure (leaks) along the landward slope. Recommend removing vegetation along pipe alignment to conduct proper inspection of structure. (W. Wylie - DWR UCIP)
FIELD_STRUCT_DESC: 36-inch corrugated metal gravity drainage pipe (CMP) through the levee, 13.2 feet below the crown. Flap gate on the waterside (WS) end. Concrete headwall on the landside (LS) end. Concrete U-shaped headwall on the WS end. Cobble revetment around both ends. [Additional Reference(s): DWR Levee Log, 2002, (HLM 0.64). USACE San Joaquin O&M Manual, Unit No. 601, Part No. 1, 1967, Amended in 1978, Revised 20 June 1985, (HLM 0.65). DWR As-Built Specification No. 63-25, Sheet No. 4, 9 May 1963, (HLM 0.65)].

LS view: Headwall barely visible at toe from crown.

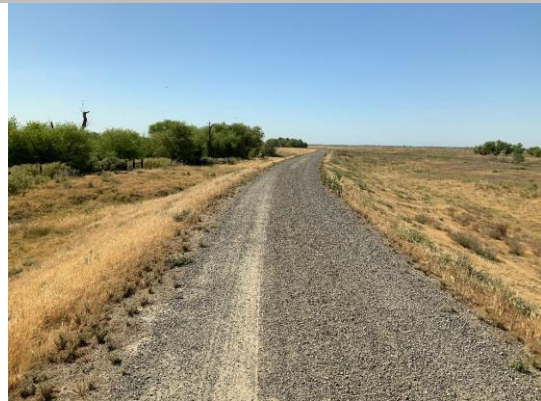
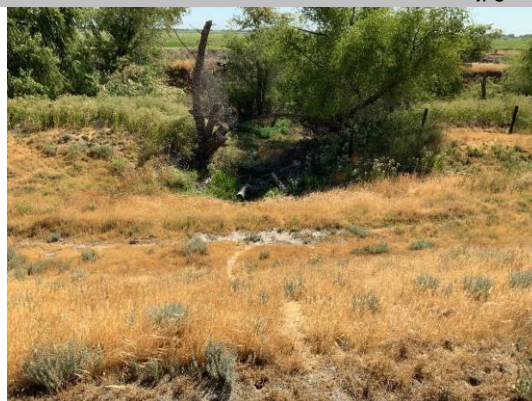
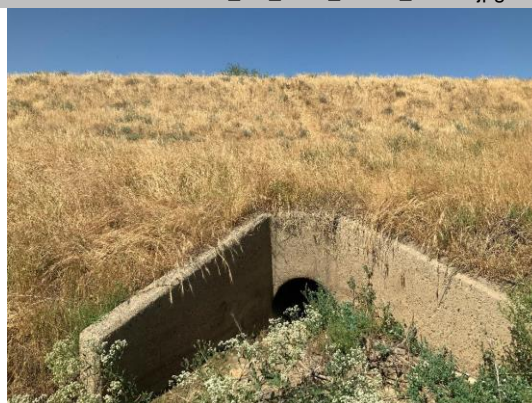
Photo 1 of 3 : UCIP_SP_2022_70988_99664.jpg

FS_ID:70988
 DS_ID:19759
 EP_NO: N/A
 Repair Type: Urgent
 Crossing Status: Found
 UCIP Comments: 06/1/2021 Record has been upgraded from No Action Needed to Urgent. DWR DMP internal inspection has found pipe integrity issues. LOF of crossing is greater than or equal to 5 and less than 6. Crossing will be monitored until funding becomes available to address the issues. No permit was found authorizing this encroachment. CVFPB will need to review crossing to determine owner. The UCIP inspection was completed with GEI staff, P. Espinoza. (H. Dunn ? GEI)
 FIELD_STRUCT_DESC: 24-inch corrugated metal gravity drainage pipe (CMP) through the levee, 14.4 feet below the crown. Flap gate on the waterside (WS) end. Concrete headwall on the landside (LS) end. Concrete U-shaped headwall on the WS end. [Additional Reference(s): DWR Levee Log, 2002, (HLM 0.84). USACE San Joaquin O&M Manual, Unit No. 601, Part No. 1, 1967, Amended in 1978, Revised 20 June 1985, (HLM 0.84). DWR As-Built Specification No. 63-25, Sheet No. 4, 9 May 1963, (HLM 0.84)].

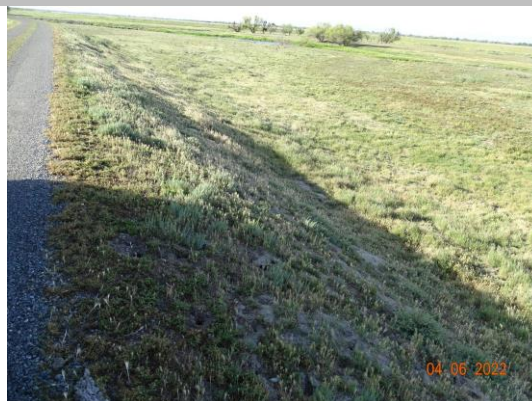
Photo 1 of 1 : SP_2022_NA0010_123_154_20220414_00364.jpg

LM Start	0.90	Rating **	A/W	Issue No.	154
LM End	0.90	Issue Type +	Ma	Location *	WS
Category	Earthen Levee			GPS Latitude/Longitude	
				Start	End
Item	Erosion / Livestock			37.271264 °	37.271264 °
				-120.811934 °	-120.811934 °
DWR ID	DWR_NA0010_05_s_2022_154				
Comment Code					
E4 : Repair the levee slope damaged by livestock and prevent large animal access.					
Inspector Comment					
Shallow depression on the lower 1/3 of the waterside slope. Possibly from livestock, but no visible trail leading to the depression.

View of minor slope erosion on the waterside. (Spring 2022)

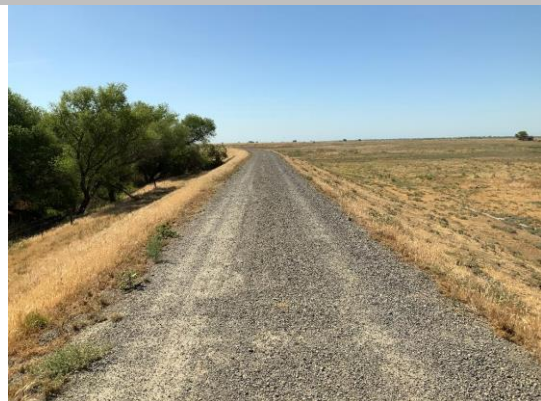
Photo 1 of 3 : UCIP_SP_2022_70989_99672.jpg

Comment Code						
Inspector Comment						
FS_ID:70989						
DS_ID:19760						
EP_NO: N/A						
Repair Type: Non-Urgent						
Crossing Status: Found						
UCIP Comments: 06/1/2021 The record has been upgraded from No Action Needed to Non-Urgent. LS pipe inlet blocked by barbed wire, could not inspect. Small pipe lodged in the WS flapgate so it cannot be closed all the way, recommend removal before flood season. No permit was found authorizing this encroachment. CVFPB will need to review crossing to determine owner. The UCIP inspection was completed with GEI staff, P. Espinoza. (H. Dunn ? GEI)						
FIELD_STRUCT_DESC: 36-inch corrugated metal gravity drainage pipe (CMP) through the levee, 21.0 feet below the crown. Flap gate on the waterside (WS) end. Concrete headwall on the landside (LS) end. Concrete U-shaped headwall on the WS end. [Additional Reference(s): DWR Levee Log, 2002, (HLM 1.44). USACE San Joaquin O&M Manual, Unit No. 601, Part No. 1, 1967, Amended in 1978, Revised 20 June 1985, (HLM 1.44). DWR As-Built Specification No. 63-25, Sheet No. 4, 9 May 1963, (HLM 1.44)].

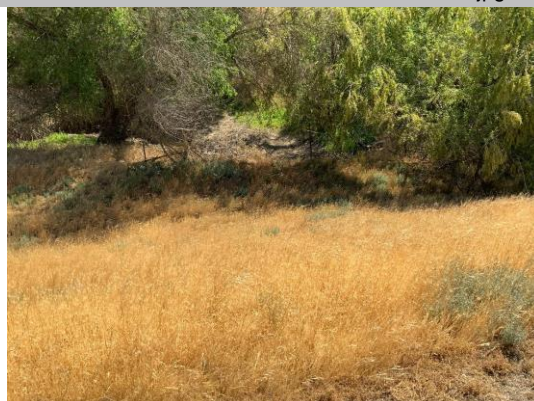
Photo 2 of 3 : UCIP_SP_2022_70989_99670.jpg

LS view: Toe from crown.

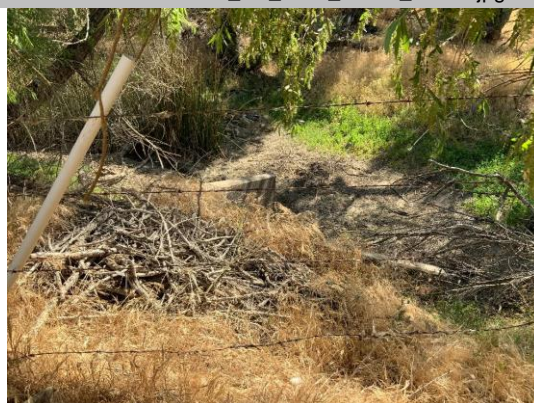
Photo 3 of 3 : UCIP_SP_2022_70989_99671.jpg

LS view: Headwall barely visible at toe behind barbed wire.

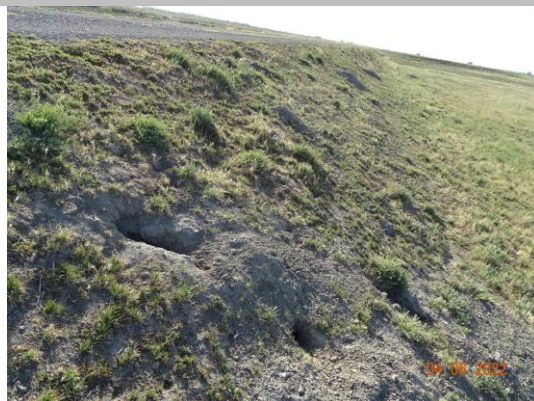
Photo 1 of 1 : SP_2022_NA0010_123_156_20220414_00365.jpg

LM Start	1.53	Rating **	U	Issue No.	156
LM End	1.53	Issue Type +	Ma	Location *	WS
Category	Earthen Levee			GPS Latitude/Longitude	
				Start	End
Item	Animal Control			37.265008 °	37.265008 °
				-120.804010 °	-120.804010 °
DWR ID	DWR_NA0010_05_s_2022_156				
Comment Code					
A3 : No rodents visible, but rodent burrows visible; need to backfill and compact or grout burrows.					
Inspector Comment					
Several rodent burrows observed. A few appear to penetrate the levee through to the landside.

Several rodent holes observed on the waterside slope. (Spring 2022)

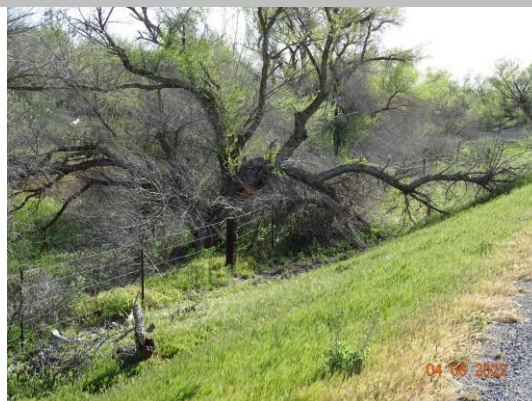
Photo 1 of 1 : SP_2022_NA0010_123_102_20220414_00366.jpg

LM Start	2.82	Rating **	M	Issue No.	102
LM End	2.82	Issue Type +	Ma	Location *	LS
Category	Earthen Levee			GPS Latitude/Longitude	
				Start	End
Item	Encroachments			37.256805 °	37.256805 °
				-120.785434 °	-120.785434 °
DWR ID	DWR_NA0010_05_s_2019_102				
Comment Code					
TR : Tree or limb					
Inspector Comment

Tree limb has fallen on the landside slope and toe. (Spring 2022)

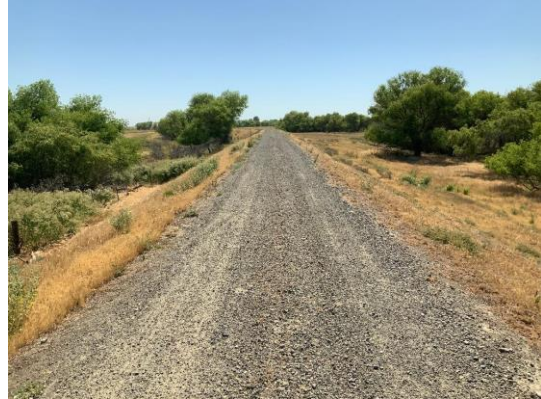
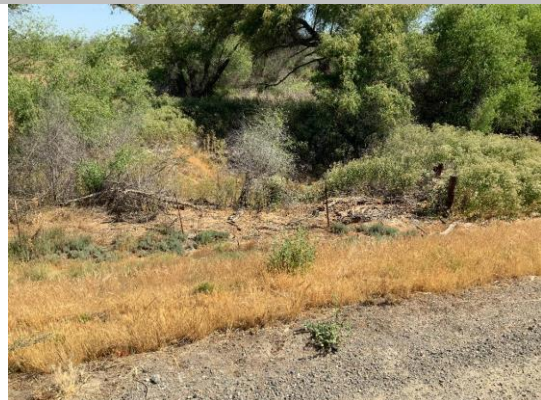
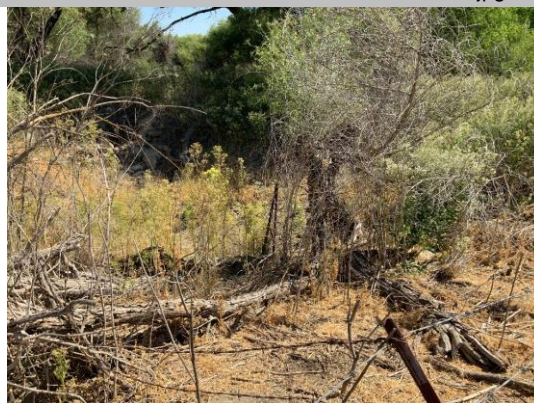
Comment Code					
Inspector Comment					
FS_ID:70990 DS_ID:19809 EP_NO: N/A Repair Type: Non-Urgent Crossing Status: Found UCIP Comments: 06/1/2021 Record remains Non-Urgent. DWR DMP internal inspection has found pipe integrity issues. LOF of crossing is between 4.1 and 5. Crossing will be monitored until funding becomes available for rehabilitation. Barbed wire over LS end, could not inspect. No permit was found authorizing this encroachment. CVFPB will need to review crossing to determine owner. The UCIP inspection was completed with GEI staff, P. Espinoza. (H. Dunn ? GEI) 04/09/2014 Log partially blocking inlet at LS toe. (W. Wylie - DWR UCIP) FIELD_STRUCT_DESC: 24-inch corrugated metal gravity drainage pipe (CMP) through the levee, 15.0 feet below the crown. Flap gate on the waterside (WS) end. Concrete U-shaped headwall on each end. [Additional Reference(s): DWR Levee Log, 2002, (HLM 2.83). USACE San Joaquin O&M Manual, Unit No. 601, Part No. 1, 1967, Amended in 1978, Revised 20 June 1985, (HLM 2.85). DWR As-Built Specification No. 63-25, Sheet No. 5, 9 May 1963, (HLM 2.85)]. FS Date: 6/1/2021

Levee crown looking downstream.

LS view: Toe from crown.

LS view: Headwall barely visible at toe behind barbed wire.

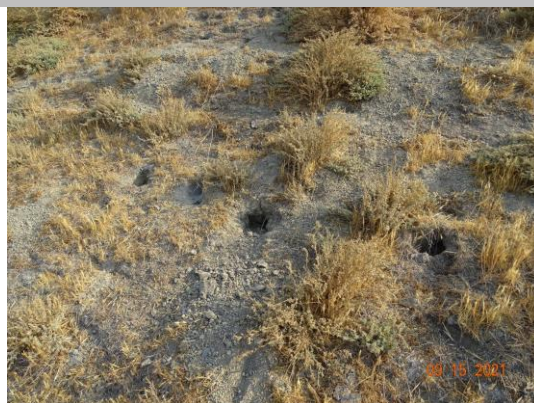
Photo 1 of 1 : SP_2022_NA0010_123_127_20220308_00027.jpg

LM Start	3.23	Rating **	A/W	Issue No.	127
LM End	3.23	Issue Type +	Ma	Location *	WS
Category	Earthen Levee			GPS Latitude/Longitude	
				Start	End
Item	Animal Control			37.256278 °	37.256278 °
				-120.778404 °	-120.778404 °
DWR ID	DWR_NA0010_05_s_2022_127				
Comment Code					
A3 : No rodents visible, but rodent burrows visible; need to backfill and compact or grout burrows.					
Inspector Comment

View of rodent holes in the water side slope. (Fall 2021)

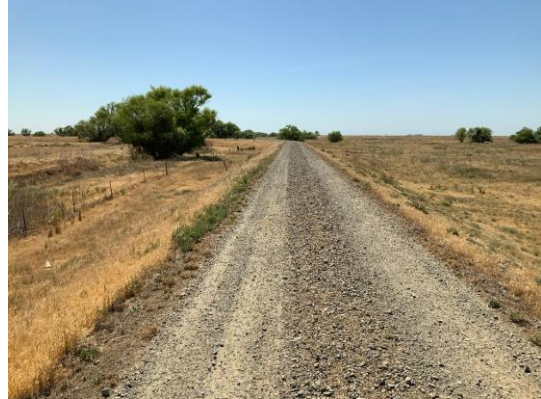
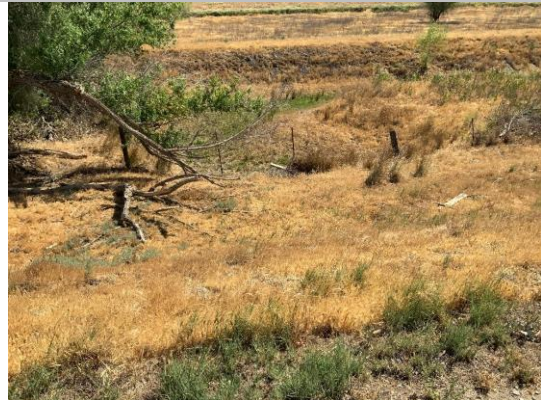
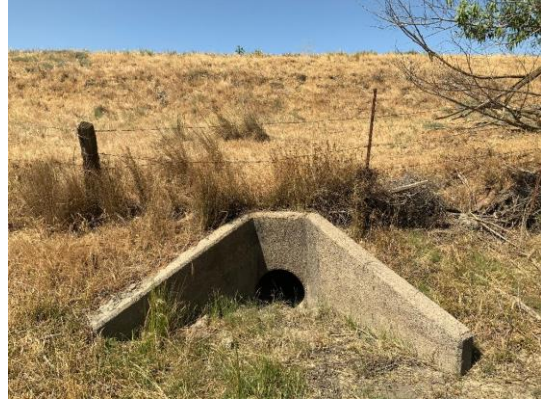
Comment Code					
Inspector Comment					
FS_ID:70991 DS_ID:19810 EP_NO: N/A Repair Type: Non-Urgent Crossing Status: Found UCIP Comments: 06/1/2021 Record remains Non-Urgent. DWR DMP internal inspection has found pipe integrity issues. LOF of crossing is between 4.1 and 5. Crossing will be monitored until funding becomes available for rehabilitation. Pipe is eroded through causing holes just behind the WS flapgate. Metal peeling away inside of pipe outlet. Flapgate is rusted with some corrosion. No permit was found authorizing this encroachment. CVFPB will need to review crossing to determine owner. The UCIP inspection was completed with GEI staff, P. Espinoza. (H. Dunn ? GEI) 04/15/2014 Pipe corroded through at flapgate on WS toe. (W. Wylie - DWR UCIP) FIELD_STRUCT_DESC: 24-inch corrugated metal gravity drainage pipe (CMP) through the levee, 14.7 feet below the crown. Flap gate on the waterside (WS) end. Concrete U-shaped headwall on each end. [Additional Reference(s): DWR Levee Log, 2002, (HLM 3.36). USACE San Joaquin O&M Manual, Unit No. 601, Part No. 1, 1967, Amended in 1978, Revised 20 June 1985, (HLM 3.33). DWR As-Built Specification No. 63-25, Sheet No. 5, 9 May 1963, (HLM 3.33)]. FS Date: 6/1/2021

Levee crown looking downstream.

LS view: Toe from crown.

LS view: Slope and headwall at toe.

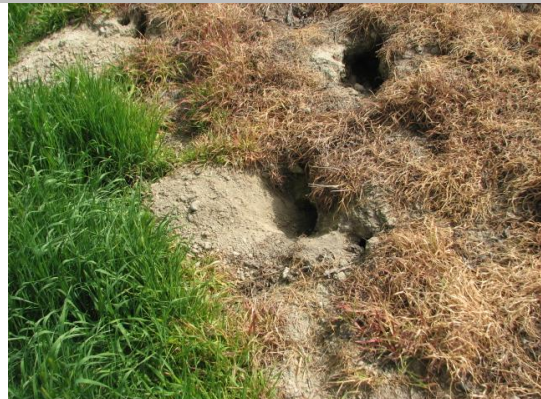
Photo 1 of 1 : SP_2022_NA0010_123_134_20220308_00032.jpg

LM Start	3.55	Rating **	M	Issue No.	134
LM End	3.55	Issue Type +	Ma	Location *	LS
Category	Earthen Levee			GPS Latitude/Longitude	
				Start	End
Item	Animal Control			37.255202 °	37.255202 °
				-120.773655 °	-120.773655 °
DWR ID	DWR_NA0010_05_f_2018_134				
Comment Code					
A3 : No rodents visible, but rodent burrows visible; need to backfill and compact or grout burrows.					
Inspector Comment					
Several rodent holes are located within this section.

Looking at typical rodent holes within this section. (Spring 2018)

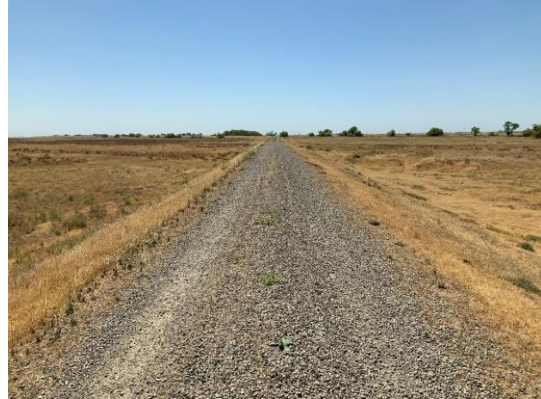
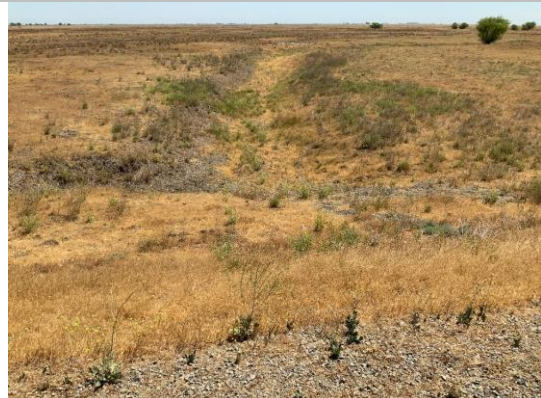
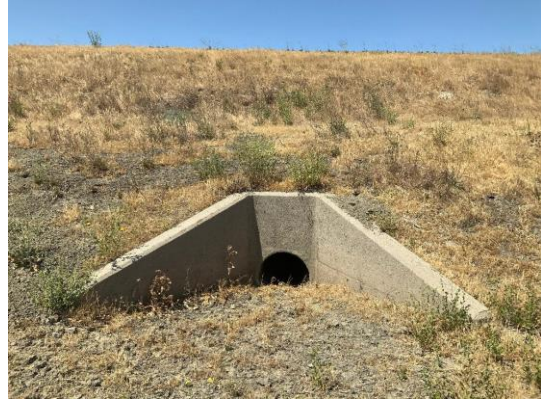
Comment Code						
Inspector Comment						
FS_ID:70992 DS_ID:19811 EP_NO: N/A Repair Type: Non-Urgent Crossing Status: Found UCIP Comments: 06/1/2021 Record remains Non-Urgent. Some debris buildup within the LS pipe inlet, recommend cleaning out. No permit was found authorizing this encroachment. CVFPB will need to review crossing to determine owner. The UCIP inspection was completed with GEI staff, P. Espinoza. (H. Dunn ? GEI) 04/16/2014 Sediment buildup in pipe visible from landward side--recommend contacting owner to clear pipe. (W. Wylie - DWR UCIP) FIELD_STRUCT_DESC: 24-inch corrugated metal gravity drainage pipe (CMP) through the levee, 15.0 feet below the crown. Flap gate on the waterside (WS) end. Concrete headwall on the landside (LS) end. Concrete U-shaped headwall on the WS end. [Additional Reference(s): DWR Levee Log, 2002, (HLM 3.67). USACE San Joaquin O&M Manual, Unit No. 601, Part No. 1, 1967, Amended in 1978, Revised 20 June 1985, (HLM 3.67). DWR As-Built Specification No. 63-25, Sheet No. 6, 9 May 1963, (HLM 3.67)]. FS Date: 6/1/2021

Levee crown looking downstream.

LS view: Toe from crown.

LS view: Slope and headwall at toe.

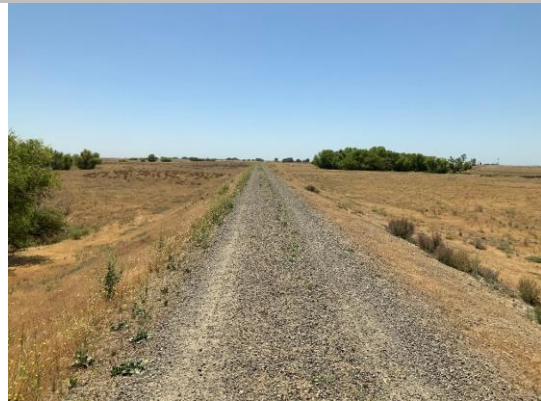
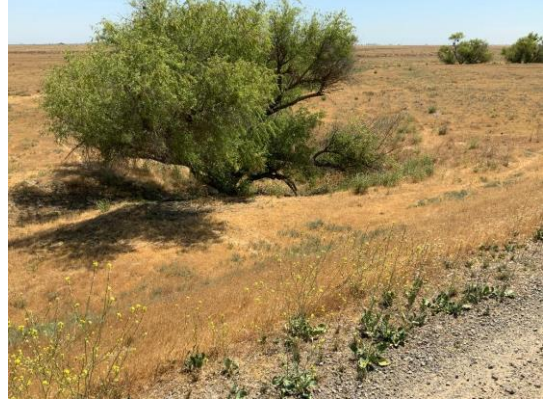
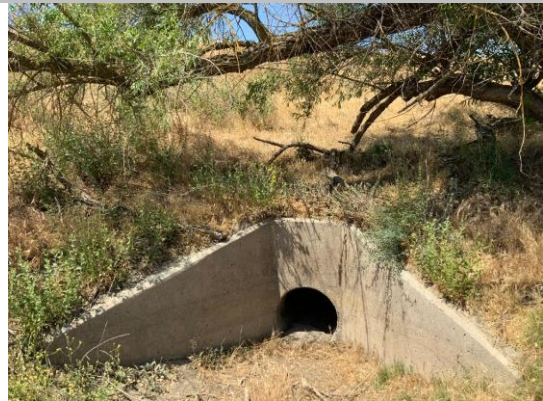
FS_ID:70993
DS_ID:19769
EP_NO: N/A
Repair Type: Non-Urgent
Crossing Status: Found
UCIP Comments: 06/1/2021 Record remains Non-Urgent. Some sediment buildup in LS pipe inlet, recommend cleaning out. No permit was found authorizing this encroachment. CVFPB will need to review crossing to determine owner. The UCIP inspection was completed with GEI staff, P. Espinoza. (H. Dunn ? GEI) 04/16/2014 Sediment buildup in pipe visible from landward side--recommend contacting owner to clear pipe. (W. Wylie - DWR UCIP)
FIELD_STRUCT_DESC: 24-inch corrugated metal gravity drainage pipe (CMP) through the levee, 16.0 feet below the crown. Flap gate on the waterside (WS) end. Concrete U-shaped headwall on each end. [Additional Reference(s): DWR Levee Log, 2002, (HLM 4.01). USACE San Joaquin O&M Manual, Unit No. 601, Part No. 1, 1967, Amended in 1978, Revised 20 June 1985, (HLM 4.02). DWR As-Built Specification No. 63-25, Sheet No. 6, 9 May 1963, (HLM 4.02)].

Levee crown looking downstream.

LS view: Toe from crown.

LS view: Slope and headwall at toe.

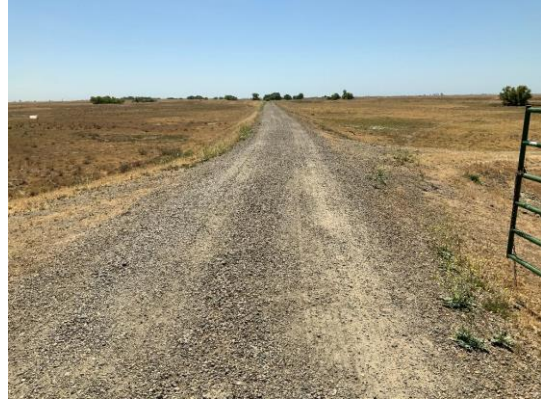
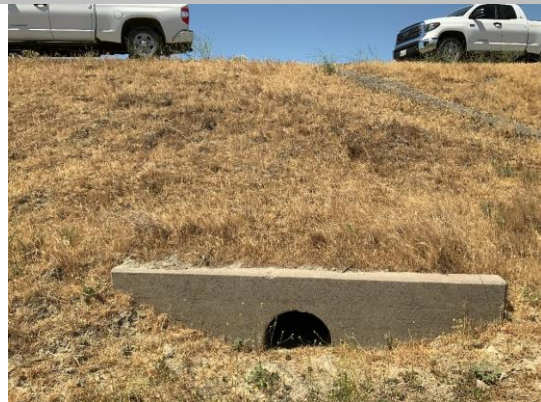
Comment Code					
Inspector Comment					
FS_ID:70994 DS_ID:19770 EP_NO: N/A Repair Type: Non-Urgent Crossing Status: Found UCIP Comments: 06/1/2021 Record remains Non-Urgent. Sizable burrow complex on WS slope, with several holes around 3-4 inches wide, recommend filling in for levee integrity. There is also sediment buildup within the LS pipe inlet, recommend cleaning out. No permit was found authorizing this encroachment. CVFPB will need to review crossing to determine owner. The UCIP inspection was completed with GEI staff, P. Espinoza. (H. Dunn ? GEI) 04/16/2014 Sediment buildup in pipe visible from landward side--recommend contacting owner to clear pipe. (W. Wylie - DWR UCIP) FIELD_STRUCT_DESC: 24-inch corrugated metal gravity drainage pipe (CMP) through the levee, 11.6 feet below the crown. Flap gate on the waterside (WS) end. Concrete headwall on the landside (LS) end. Concrete U-shaped headwall on the WS end. [Additional Reference(s): DWR Levee Log, 2002, (HLM 4.27). USACE San Joaquin O&M Manual, Unit No. 601, Part No. 1, 1967, Amended in 1978, Revised 20 June 1985, (HLM 4.27). DWR As-Built Specification No. 63-25, Sheet No. 6, 9 May 1963, (HLM 4.27)]. FS Date: 6/1/2021

Levee crown looking downstream.

LS view: Slope and headwall at toe.
