**Flood Control Project Maintenance
Levee Inspections**

Maintenance Issue Types Only, Levee Inspection Report By Mile - Spring 2022

Lower San Joaquin Levee District

Waterway	Bank	Unit Miles	Inspection Start/End	Inspector
Unit No. 01 San Joaquin River	Right	22.52	04/05/2022 04/05/2022	Corey Fujitani

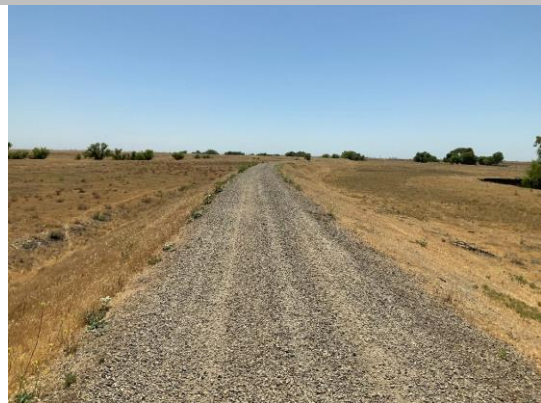
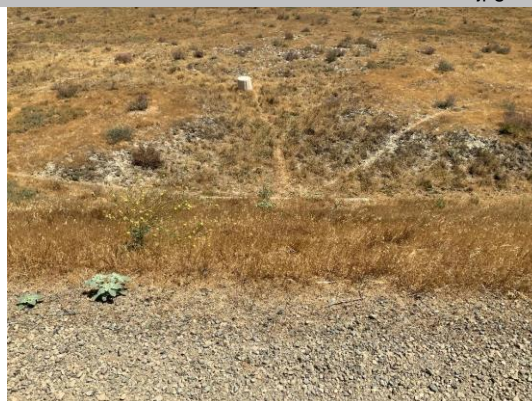
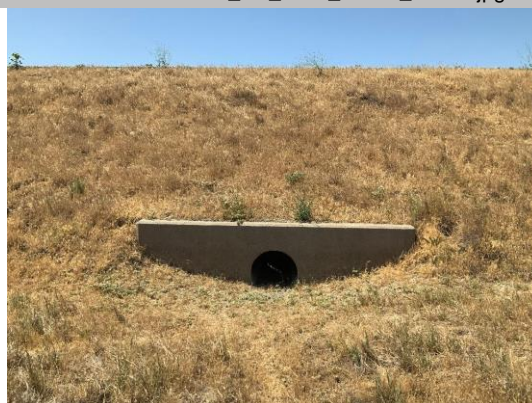
Comment Code					
Inspector Comment					
FS_ID:70995 DS_ID:19771 EP_NO: N/A Repair Type: Non-Urgent Crossing Status: Found UCIP Comments: 06/1/2021 Record remains Non-Urgent. LS pipe inlet has sediment buildup inside, recommend cleaning out. No permit was found authorizing this encroachment. CVFPB will need to review crossing to determine owner. The UCIP inspection was completed with GEI staff, P. Espinoza. (H. Dunn ? GEI) 04/16/2014 Sediment buildup in pipe visible from landward side--recommend contacting owner to clear pipe. (W. Wylie - DWR UCIP) FIELD_STRUCT_DESC: 24-inch corrugated metal gravity drainage pipe (CMP) through the levee, 12.0 feet below the crown. Flap gate on the waterside (WS) end. Concrete headwall on the landside (LS) end. Concrete U-shaped headwall on the WS end. [Additional Reference(s): DWR Levee Log, 2002, (HLM 4.53). USACE San Joaquin O&M Manual, Unit No. 601, Part No. 1, 1967, Amended in 1978, Revised 20 June 1985, (HLM 4.54). DWR As-Built Specification No. 63-25, Sheet No. 6, 9 May 1963, (HLM 4.54)]. FS Date: 6/1/2021

Levee crown looking downstream.

LS view: Toe from crown.

LS view: Slope and headwall at toe.

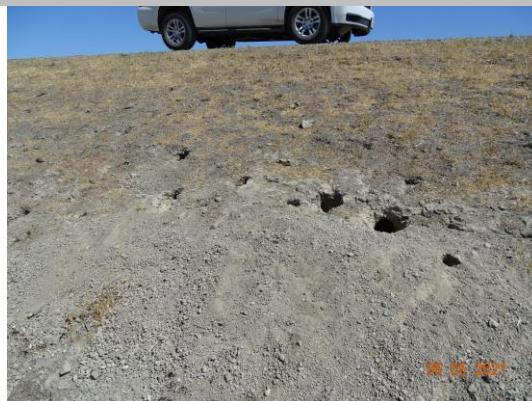
Photo 1 of 1 : SP_2022_NA0010_123_100_20220308_00010.jpg

LM Start	4.85	Rating **	M	Issue No.	100
LM End	4.85	Issue Type +	Ma	Location *	WS
Category	Earthen Levee			GPS Latitude/Longitude	
				Start	End
Item	Animal Control			37.241127 °	37.241127 °
				-120.752398 °	-120.752398 °
DWR ID	DWR_NA0010_05_s_2021_100				
Comment Code					
A1 : Exterminate rodents and backfill and compact or grout burrows.					
Inspector Comment					
Several burrows and rodents observed at this location. Bait stations have been set up.

Several rodent burrows noted at this location. (Spring 2021)

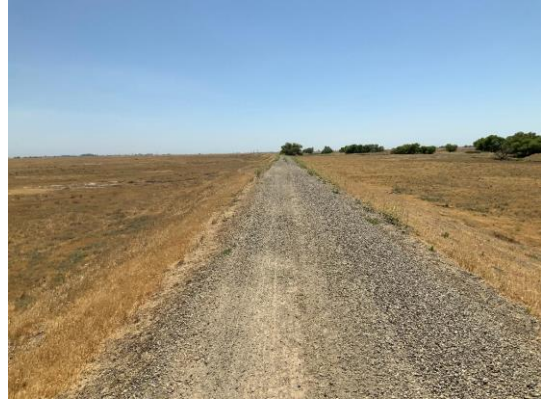
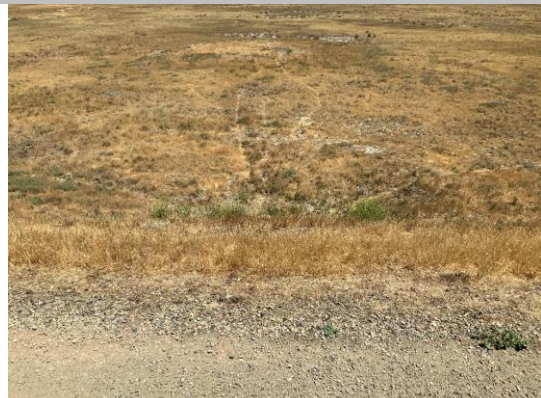
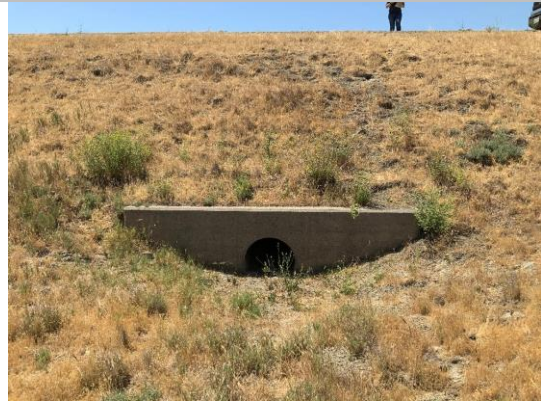
Comment Code						
Inspector Comment						
FS_ID:70996 DS_ID:19772 EP_NO: N/A Repair Type: Non-Urgent Crossing Status: Found UCIP Comments: 06/1/2021 The record remains Non-Urgent. LS pipe inlet has sediment buildup, recommend cleaning out. No permit was found authorizing this encroachment. CVFPB will need to review crossing to determine owner. The UCIP inspection was completed with GEI staff, P. Espinoza. (H. Dunn ? GEI) 04/16/2014 Heavy sediment buildup in pipe visible from landward side--recommend contacting owner to clear pipe. (W. Wylie - DWR UCIP) FIELD_STRUCT_DESC: 24-inch corrugated metal gravity drainage pipe (CMP) through the levee, 12.3 feet below the crown. Flap gate on the waterside (WS) end. Concrete headwall on the landside (LS) end. Concrete U-shaped headwall on the WS end. [Additional Reference(s): DWR Levee Log, 2002, (HLM 4.89). USACE San Joaquin O&M Manual, Unit No. 601, Part No. 1, 1967, Amended in 1978, Revised 20 June 1985, (HLM 4.89). DWR As-Built Specification No. 63-25, Sheet No. 7, 9 May 1963, (HLM 4.89)]. FS Date: 6/1/2021

Levee crown looking downstream.

LS view: Toe from crown.

LS view: Slope and headwall at toe.

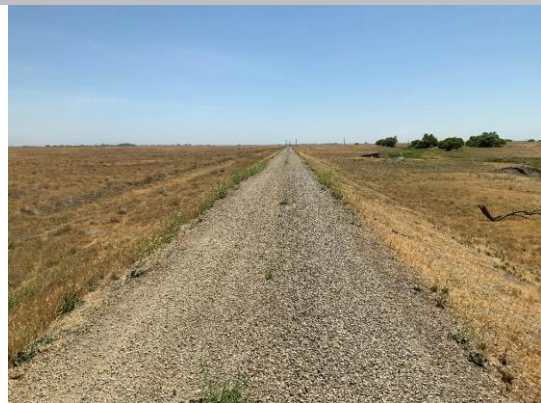
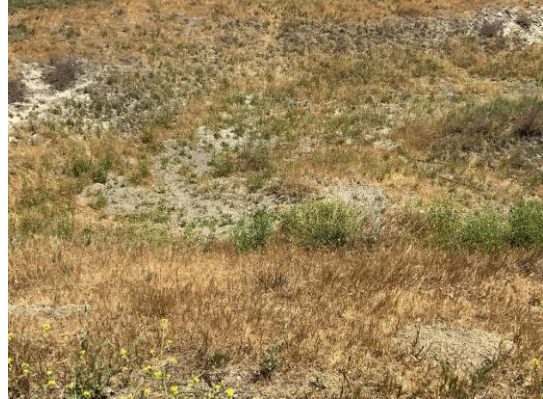
FS_ID:70997
DS_ID:19773
EP_NO: N/A
Repair Type: Non-Urgent
Crossing Status: Found
UCIP Comments: 06/1/2021 The record remains Non-Urgent. Crossing appears to be in good condition. No permit was found authorizing this encroachment. CVFPB will need to review crossing to determine owner. The UCIP inspection was completed with GEI staff, P. Espinoza. (H. Dunn ? GEI) 04/16/2014 Heavy sediment buildup in pipe visible from landward side--recommend contacting owner to clear pipe. (W. Wylie - DWR UCIP)
FIELD_STRUCT_DESC: 24-inch corrugated metal gravity drainage pipe (CMP) through the levee, 12.2 feet below the crown. Flap gate on the waterside (WS) end. Concrete headwall on the landside (LS) end. Concrete U-shaped headwall on the WS end. [Additional Reference(s): DWR Levee Log, 2002, (HLM 5.14). USACE San Joaquin O&M Manual, Unit No. 601, Part No. 1, 1967, Amended in 1978, Revised 20 June 1985, (HLM 5.15). DWR As-Built Specification No. 63-25, Sheet No. 7, 9 May 1963, (HLM 5.15)].

Levee crown looking upstream.

LS view: Toe from crown.

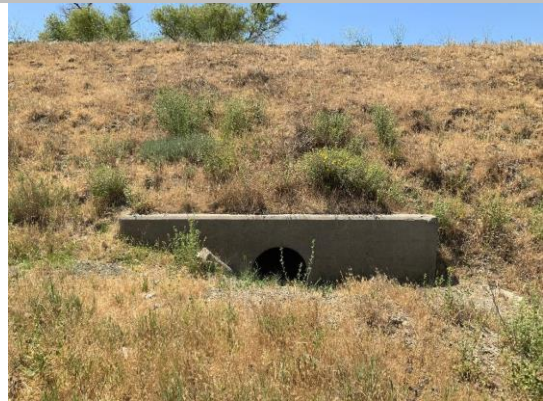
Photo 3 of 3 : UCIP_SP_2022_70997_100754.jpg

LS view: Slope and headwall at toe.

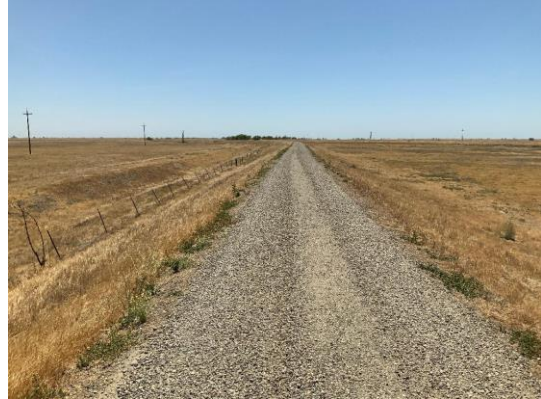
Photo 1 of 3 : UCIP_SP_2022_70998_100766.jpg

Comment Code						
Inspector Comment						
FS_ID:70998 DS_ID:19774 EP_NO: N/A Repair Type: Non-Urgent Crossing Status: Found UCIP Comments: 06/1/2021 The record has been upgraded from No Action Needed to Non-Urgent. Crossing appears to be in good condition. No permit was found authorizing this encroachment. CVFPB will need to review crossing to determine owner. New concrete riser, plastic riser, and flowmeter off the LS toe going away from the levee. The UCIP inspection was completed with GEI staff, P. Espinoza. (H. Dunn ? GEI) FIELD_STRUCT_DESC: 24-inch corrugated metal gravity drainage pipe (CMP) through the levee, 9.5 feet below the crown. Flap gate on the waterside (WS) end. Concrete headwall on the landside (LS) end. Concrete U-shaped headwall on the WS end. [Additional Reference(s): DWR Levee Log, 2002, (HLM 5.58). USACE San Joaquin O&M Manual, Unit No. 601, Part No. 1, 1967, Amended in 1978, Revised 20 June 1985, (HLM 5.58). DWR As-Built Specification No. 63-25, Sheet No. 7, 9 May 1963, (HLM 5.58)]. FS Date: 6/1/2021

Levee crown looking upstream.

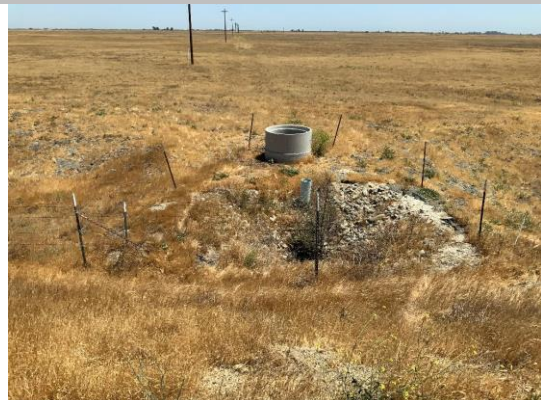
Photo 2 of 3 : UCIP_SP_2022_70998_100768.jpg

LS view: Toe from crown.

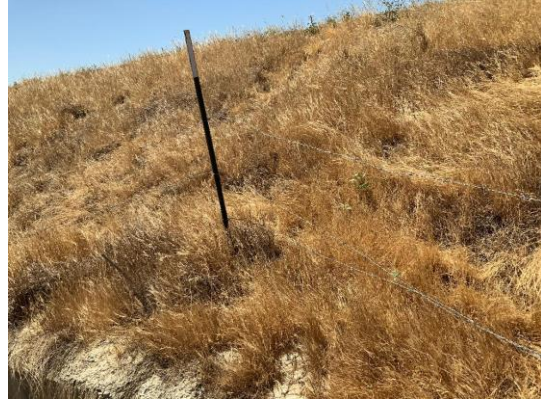
Photo 3 of 3 : UCIP_SP_2022_70998_100769.jpg

LS view: Slope from toe.

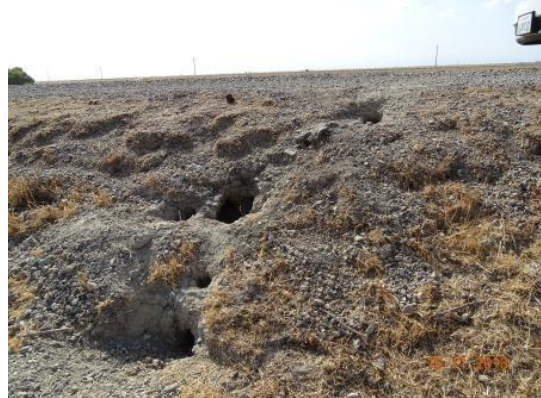
Photo 1 of 1 : SP_2022_NA0010_123_138_20220308_00034.jpg

LM Start	5.94	Rating **	U	Issue No.	138
LM End	5.94	Issue Type +	Ma	Location *	LS
Category	Earthen Levee			GPS Latitude/Longitude	
				Start	End
Item	Animal Control			37.236387 °	37.236387 °
				-120.734164 °	-120.734164 °
DWR ID	DWR_NA0010_05_f _ 2018_138				
Comment Code					
A1 : Exterminate rodents and backfill and compact or grout burrows.					
Inspector Comment					
Several large rodent holes are located at this location.

View of large rodent holes in landside slope. (Fall 2018)

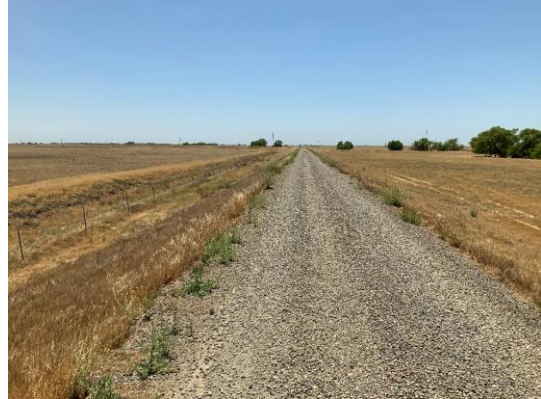
Photo 1 of 3 : UCIP_SP_2022_70999_100772.jpg

Comment Code						
Inspector Comment						
FS_ID:70999 DS_ID:19775 EP_NO: N/A Repair Type: Non-Urgent Crossing Status: Found UCIP Comments: 06/1/2021 The record has been upgraded from No Action Needed to Non-Urgent. LS inlet blocked by barbed wire and was inaccessible, could not inspect. No permit was found authorizing this encroachment. CVFPB will need to review crossing to determine owner. The UCIP inspection was completed with GEI staff, P. Espinoza. (H. Dunn ? GEI) FIELD_STRUCT_DESC: 24-inch corrugated metal gravity drainage pipe (CMP) through the levee, 13.0 feet below the crown. Flap gate on the waterside (WS) end. Concrete headwall on the landside (LS) end. Concrete U-shaped headwall on the WS end. [Additional Reference(s): DWR Levee Log, 2002, (HLM 6.35). USACE San Joaquin O&M Manual, Unit No. 601, Part No. 1, 1967, Amended in 1978, Revised 20 June 1985, (HLM 6.35). DWR As-Built Specification No. 63-25, Sheet No. 8, 9 May 1963, (HLM 6.35)]. FS Date: 6/1/2021

Levee crown looking upstream.

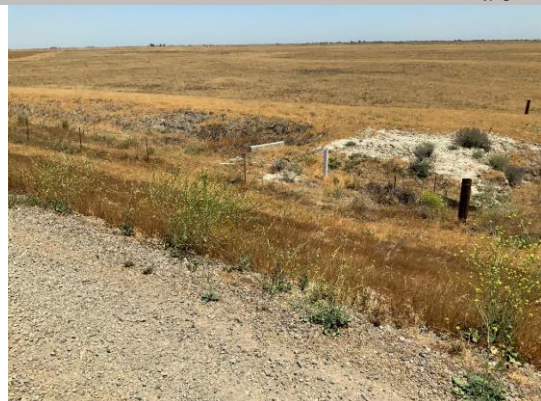
Photo 2 of 3 : UCIP_SP_2022_70999_100776.jpg

LS view: Toe from crown.

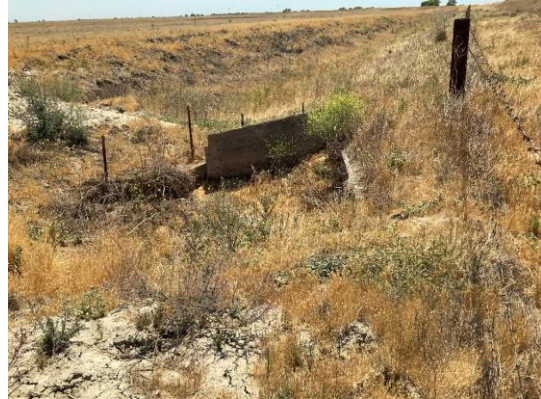
Photo 3 of 3 : UCIP_SP_2022_70999_100771.jpg

LS view: Headwall visible at toe behind barbed wire.

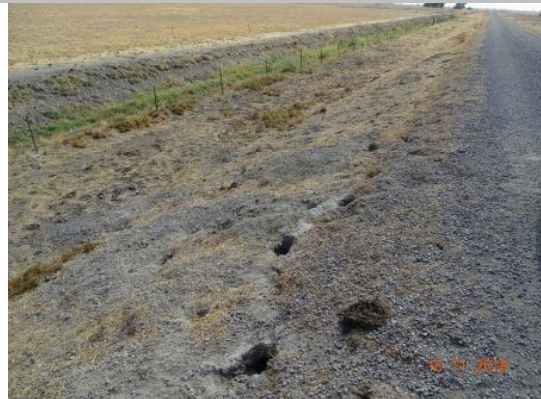
Photo 1 of 1 : SP_2022_NA0010_123_139_20220308_00035.jpg

LM Start	6.40	Rating **	M	Issue No.	139
LM End	6.40	Issue Type +	Ma	Location *	LS
Category	Earthen Levee			GPS Latitude/Longitude	
				Start	End
Item	Animal Control			37.231900 °	37.231900 °
				-120.728345 °	-120.728345 °
DWR ID	DWR_NA0010_05_f_2018_139				
Comment Code					
A1 : Exterminate rodents and backfill and compact or grout burrows.					
Inspector Comment

View of rodent holes on landside shoulder. (Fall 2018)

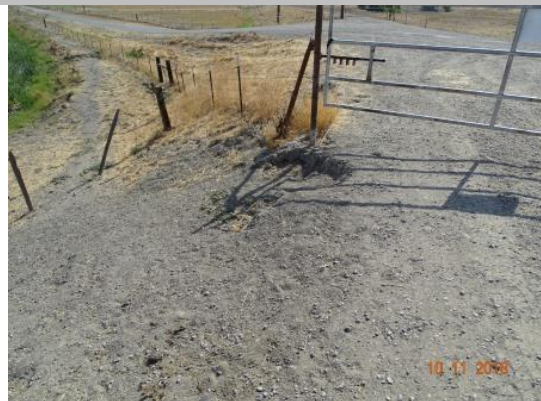
Photo 1 of 1 : SP_2022_NA0010_123_140_20220308_00036.jpg

LM Start	6.56	Rating **	A/W	Issue No.	140
LM End	6.56	Issue Type +	Ma	Location *	LS
Category	Earthen Levee			GPS Latitude/Longitude	
				Start	End
Item	Erosion / Livestock			37.230013 °	37.230013 °
				-120.726832 °	-120.726832 °
DWR ID	DWR_NA0010_05_f_2018_140				
Comment Code					
E4 : Repair the levee slope damaged by livestock and prevent large animal access.					
Inspector Comment					
Erosion onslope near the gate has been repaired with loose material. Monitor for settlement.

Erosion on landward slope caused by foot traffic. (Fall 2018)

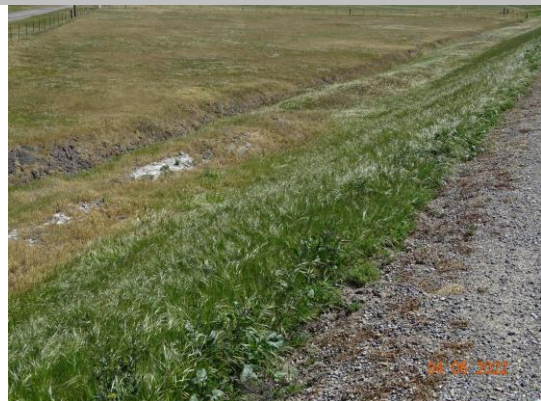
Photo 1 of 1 : SP_2022_NA0010_123_159_20220414_00367.jpg

LM Start	6.59	Rating **	M	Issue No.	159
LM End	7.13	Issue Type +	Ma	Location *	LS
Category	Earthen Levee			GPS Latitude/Longitude	
				Start	End
Item	Vegetation			37.229667 °	37.226424 °
				-120.726328 °	-120.717596 °
DWR ID	DWR_NA0010_05_s_2022_159				
Comment Code					
V1 : Control annual grass and weeds on the levee slopes and easements.					
Inspector Comment

View of vegetation on the landside slope looking upstream. (Spring 2022)

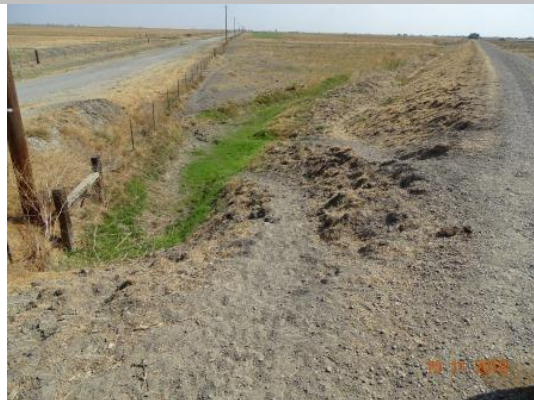
Photo 1 of 1 : SP_2022_NA0010_123_1309_20220308_00065.jpg

LM Start	6.59	Rating **	A/W	Issue No.	1309
LM End	6.59	Issue Type +	Ma	Location *	LS
Category	Earthen Levee			GPS Latitude/Longitude	
				Start	End
Item	Erosion / Livestock			37.229682 °	37.229682 °
				-120.726305 °	-120.726305 °
DWR ID	DWR_NA0010_05_s _ 2015_1309				
Comment Code					
E4 : Repair the levee slope damaged by livestock and prevent large animal access.					
Inspector Comment					
The landside slope has damage caused by animal foot traffic.

Looking upstream at damaged landside slope. (Fall 2018)

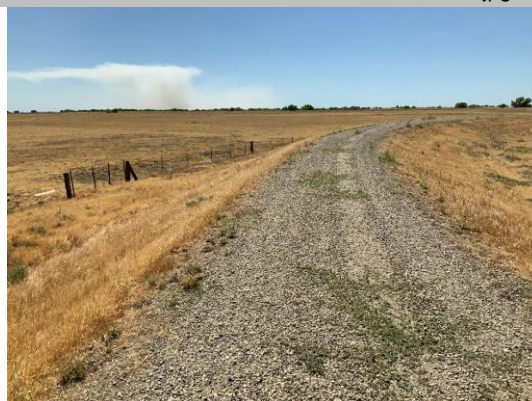
Photo 1 of 3 : UCIP_SP_2022_71000_100780.jpg

Comment Code					
Inspector Comment					
FS_ID:71000 DS_ID:19761 EP_NO: N/A Repair Type: Non-Urgent Crossing Status: Found UCIP Comments: 06/9/2021 The record remains Non-Urgent. Sediment buildup in LS pipe inlet, recommend removal. No permit was found authorizing this encroachment. CVFPB will need to review crossing to determine owner. The UCIP inspection was completed with GEI staff, P. Espinoza. (H. Dunn ? GEI) 04/22/2014 Sediment buildup in pipe visible from landward side--recommend contacting owner to clear pipe. (W. Wylie - DWR UCIP) FIELD_STRUCT_DESC: 24-inch corrugated metal gravity drainage pipe (CMP) through the levee, 12.0 feet below the crown. Flap gate on the waterside (WS) end. Concrete headwall on the landside (LS) end. Concrete U-shaped headwall on the WS end. [Additional Reference(s): DWR Levee Log, 2002, (HLM 7.36). USACE San Joaquin O&M Manual, Unit No. 601, Part No. 1, 1967, Amended in 1978, Revised 20 June 1985, (HLM 7.36). DWR As-Built Specification No. 63-25, Sheet No. 8, 9 May 1963, (HLM 7.36)]. FS Date: 6/9/2021

Levee crown looking upstream.

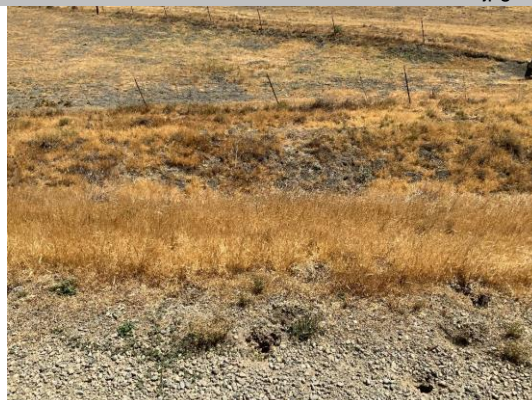
Photo 2 of 3 : UCIP_SP_2022_71000_100777.jpg

LS view: Toe from crown.

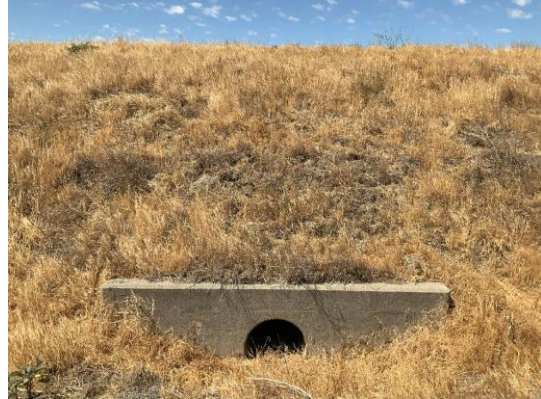
Photo 3 of 3 : UCIP_SP_2022_71000_100778.jpg

LS view: Slope and headwall at toe.

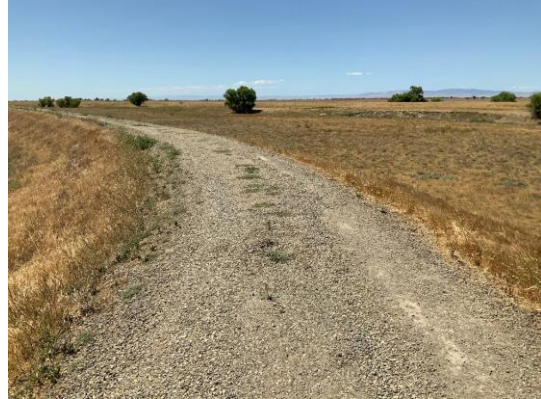
Photo 1 of 3 : UCIP_SP_2022_71002_100805.jpg

Comment Code						
Inspector Comment						
FS_ID:71002 DS_ID:19844 EP_NO: N/A Repair Type: Non-Urgent Crossing Status: Found UCIP Comments: 06/9/2021 The record has been upgraded from No Action Needed to Non-Urgent. DWR DMP internal inspection has not found pipe integrity issues. LOF of crossing is less or equal to 4.0. Recommend next video inspection in 5 years. No permit was found authorizing this encroachment. CVFPB will need to review crossing to determine owner. The UCIP inspection was completed with GEI staff, P. Espinoza. (H. Dunn ? GEI) 08/01/2018 USACE O&M manual has pipe listed under Unit 10 HLM 0.02, however, based on the current levee alignment pipe is located under Unit 5 CLM 7.68. Discrepancy in pipe O&M reference is based on reference between Historic Levee Alignment and Current Levee Alignment. (DWR UCIP - O. Magana) FIELD_STRUCT_DESC: 24-inch corrugated metal gravity drainage pipe (CMP) through the levee, 9.4 feet below the crown. Flap gate on the waterside (WS) end. Concrete headwall on the landside (LS) end. Concrete U-shaped headwall on the WS end. [Additional Reference(s): DWR Levee Log, 2002. USACE San Joaquin O&M Manual, Unit No. 601, Part No. 1, 1967, Amended in 1978, Revised 20 June 1985, (recorded as Unit 10 HLM 0.02, located in Unit 5 CLM 7.68)]. FS Date: 6/9/2021

Levee crown looking upstream.

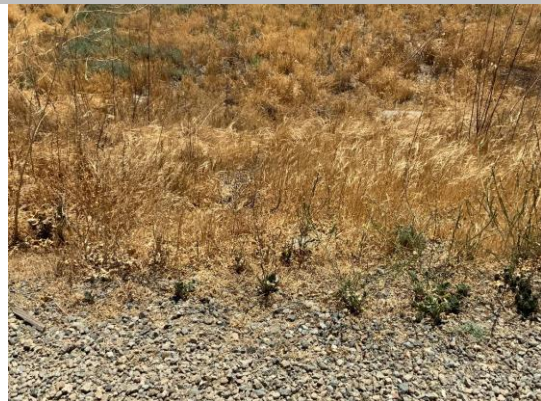
Photo 2 of 3 : UCIP_SP_2022_71002_100809.jpg

LS view: Toe from crown.

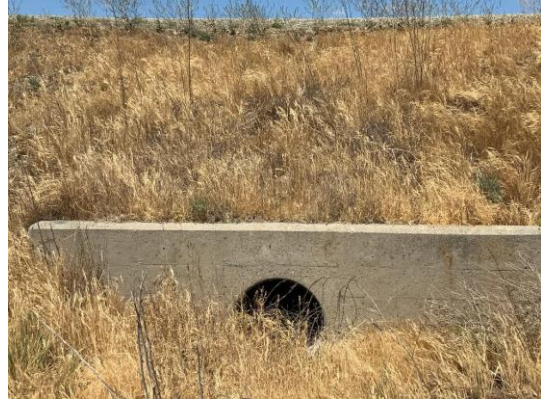
Photo 3 of 3 : UCIP_SP_2022_71002_100803.jpg

LS view: Slope and headwall at toe.

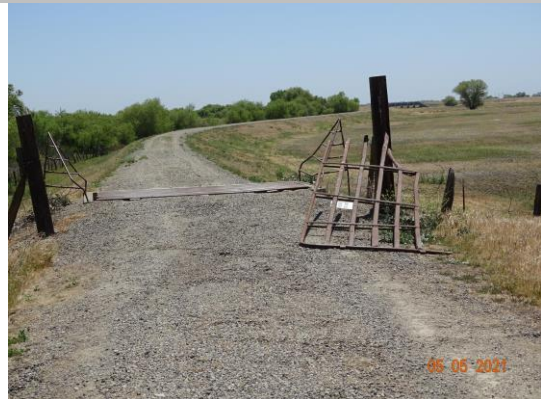
Photo 1 of 1 : SP_2022_NA0010_123_104_20220308_00012.jpg

LM Start	8.09	Rating **	M	Issue No.	104
LM End	8.09	Issue Type +	Ma	Location *	CR
Category	Earthen Levee			GPS Latitude/Longitude	
				Start	End
Item	Access Gates			37.213580 °	37.213580 °
				-120.706550 °	-120.706550 °
DWR ID	DWR_NA0010_05_s_2017_104				
Comment Code					
Inspector Comment					
The gate has completely broken and should be replaced or removed.

View of gate broken on the waterside shoulder. (Spring 2021)

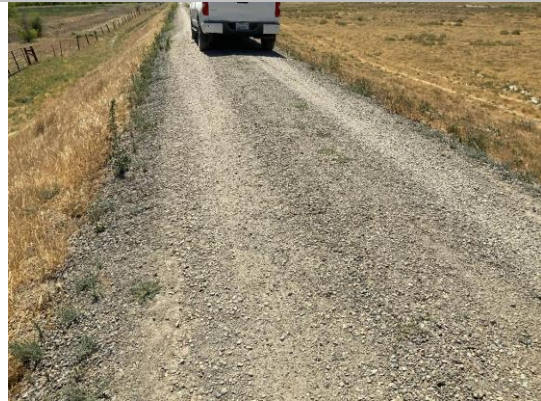
Photo 1 of 3 : UCIP_SP_2022_71003_100811.jpg

Comment Code						
Inspector Comment						
FS_ID:71003 DS_ID:19763 EP_NO: N/A Repair Type: Non-Urgent Crossing Status: Found UCIP Comments: 06/9/2021 The record remains Non-Urgent. Barbed wire over LS pipe inlet, limited inspection due to inaccessability. No permit was found authorizing this encroachment. CVFPB will need to review crossing to determine owner. The UCIP inspection was completed with GEI staff, P. Espinoza. (H. Dunn ? GEI) 04/22/2014 Pipe filled with silt on LS toe and should be cleared. (W. Wylie - DWR UCIP) FIELD_STRUCT_DESC: 24-inch corrugated metal gravity drainage pipe (CMP) through the levee, 16.0 feet below the crown. Flap gate on the waterside (WS) end. Concrete headwall on the landside (LS) end. Concrete U-shaped headwall on the WS end. [Additional Reference(s): DWR Levee Log, 2002, (HLM 8.45). USACE San Joaquin O&M Manual, Unit No. 601, Part No. 1, 1967, Amended in 1978, Revised 20 June 1985, (HLM 8.44). DWR As-Built Specification No. 63-25, Sheet No. 9, 9 May 1963, (HLM 8.44)]. FS Date: 6/9/2021

Levee crown looking upstream.

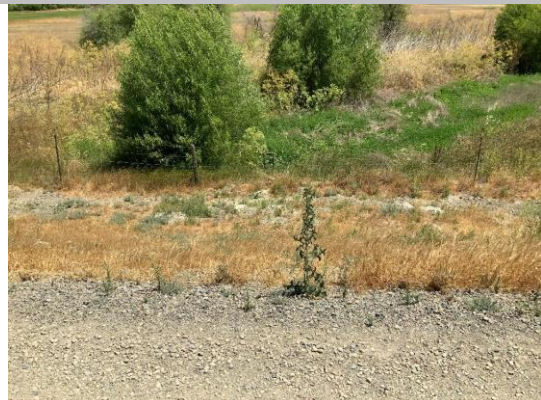
Photo 2 of 3 : UCIP_SP_2022_71003_100815.jpg

LS view: Toe from crown.

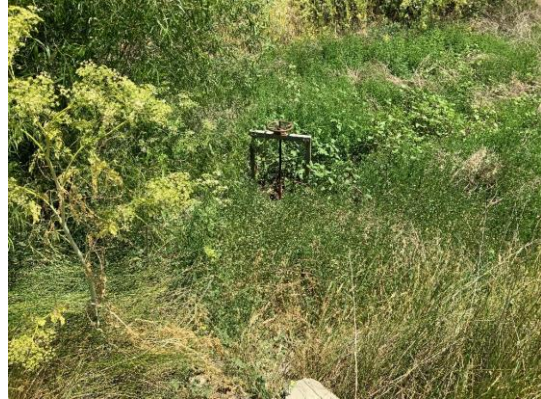
Photo 3 of 3 : UCIP_SP_2022_71003_100816.jpg

LS view: Slidegate visible at the toe behind barbed wire.

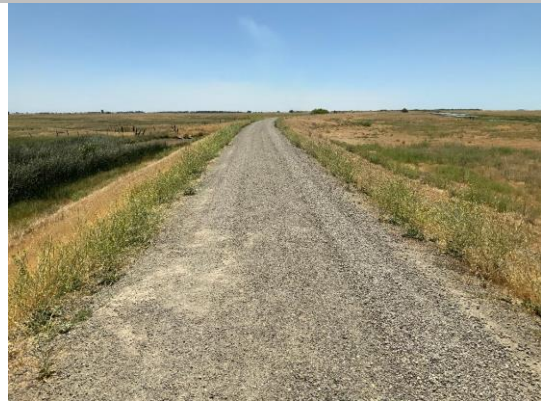
Photo 1 of 3 : UCIP_SP_2022_71009_100870.jpg

FS_ID:71009
DS_ID:19766
EP_NO: N/A
Repair Type: Non-Urgent
Crossing Status: Found
UCIP Comments: 06/9/2021 The record has been upgraded from No Action Needed to Non-Urgent. LS pipe inlet was underwater during inspection, limited inspection. WS riser is missing half of the cover causing safety hazard. The LS pipe inlet is filled with sediment, recommend removal. No permit was found authorizing this encroachment. CVFPB will need to review crossing to determine owner. The UCIP inspection was completed with GEI staff, P. Espinoza. (H. Dunn ? GEI)
FIELD_STRUCT_DESC: 36-inch corrugated metal gravity drainage pipe (CMP) through the levee, 14.8 feet below the crown. Slide gate in a 48-inch CMP riser unit on the waterside (WS) slope. Concrete headwall on each end. [Additional Reference(s): DWR Levee Log, 2002, (HLM 9.24). USACE San Joaquin O&M Manual, Unit No. 601, Part No. 1, 1967, Amended in 1978, Revised 20 June 1985, (HLM 9.26). DWR As-Built Specification No. 61-01, Sheet No. 52, 7 March 1961, (HLM 9.26)].

Levee crown looking upstream.

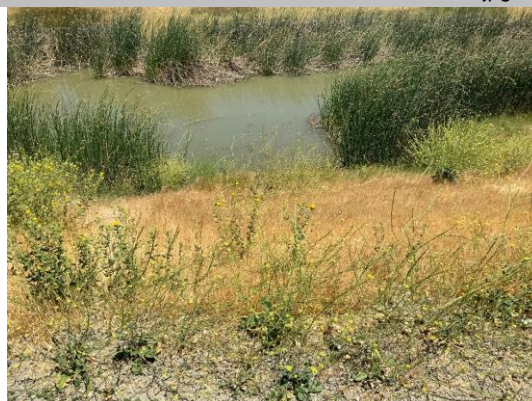
Photo 2 of 3 : UCIP_SP_2022_71009_100875.jpg

LS view: Toe from crown.

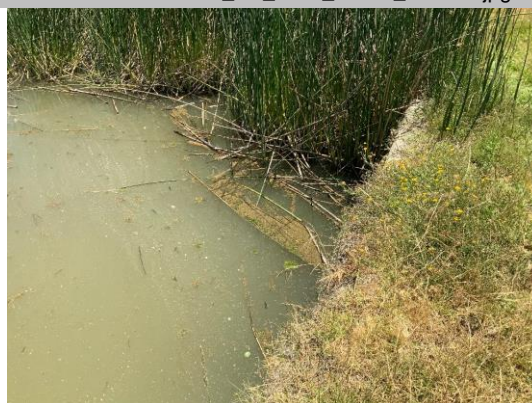
Photo 3 of 3 : UCIP_SP_2022_71009_100868.jpg

LS view: Headwall visible at toe, pipe is underwater.

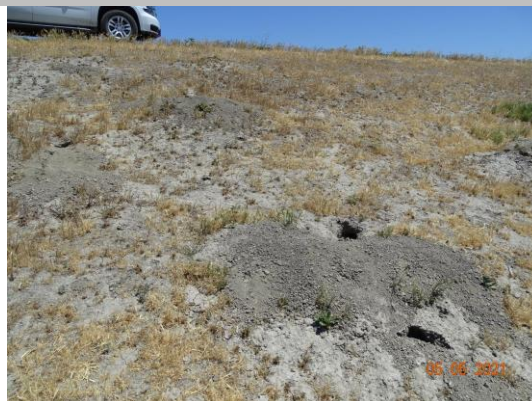
Photo 1 of 1 : SP_2022_NA0010_123_101_20220308_00011.jpg

LM Start	9.41	Rating **	M	Issue No.	101
LM End	9.45	Issue Type +	Ma	Location *	WS
Category	Earthen Levee			GPS Latitude/Longitude	
				Start	End
Item	Animal Control			37.201636 °	37.201240 °
				-120.688154 °	-120.687686 °
DWR ID	DWR_NA0010_05_s_2021_101				
Comment Code					
A3 : No rodents visible, but rodent burrows visible; need to backfill and compact or grout burrows.					
Inspector Comment

Multiple rodent holes in the waterside slope. (Spring 2021)

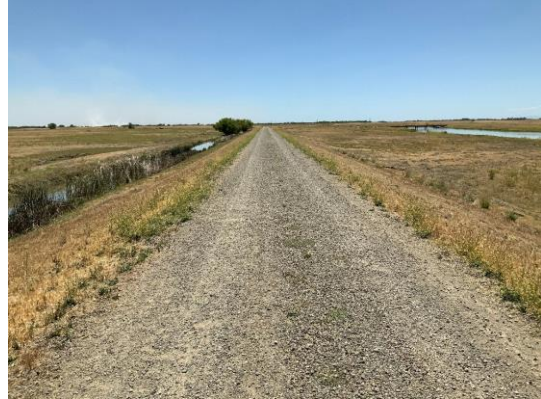
Photo 1 of 3 : UCIP_SP_2022_71010_100878.jpg

Comment Code					
Inspector Comment					
FS_ID:71010 DS_ID:19767 EP_NO: N/A Repair Type: Non-Urgent Crossing Status: Found UCIP Comments: 06/9/2021 The record remains Non-Urgent. LS pipe inlet is underwater, could not inspect. No permit was found authorizing this encroachment. CVFPB will need to review crossing to determine owner. The UCIP inspection was completed with GEI staff, P. Espinoza. (H. Dunn ? GEI) 04/22/2014 Slidegate actuator appears bent and may not work properly (WS slope). (W. Wylie - DWR UCIP) FIELD_STRUCT_DESC: 24-inch corrugated metal gravity drainage pipe (CMP) through the levee, 15.0 feet below the crown. Slide gate in a 36-inch CMP riser unit on the waterside (WS) slope. Concrete headwall on each end. [Additional Reference(s): DWR Levee Log, 2002 (HLM 10.04). USACE San Joaquin O&M Manual, Unit No. 601, Part No. 1, 1967, Amended in 1978, Revised 20 June 1985, (HLM 10.05). DWR As-Built Specification No. 61-01, Sheet No. 52, 7 March 1961, (HLM 10.05)]. FS Date: 6/9/2021

Levee crown looking upstream.

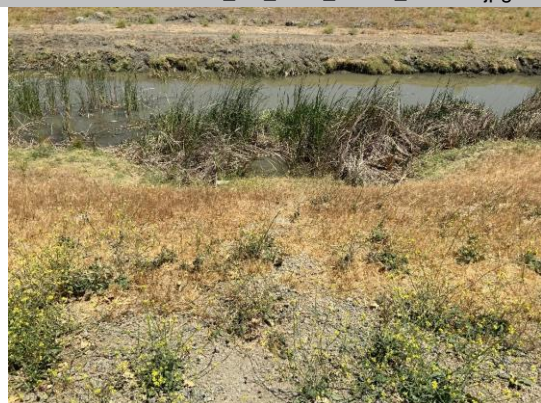
Photo 2 of 3 : UCIP_SP_2022_71010_100883.jpg

LS view: Toe from crown.

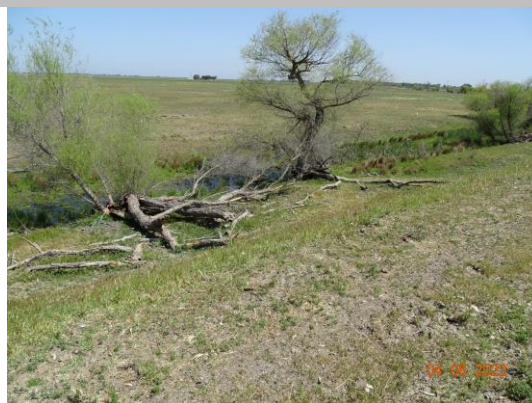
Photo 1 of 1 : SP_2022_NA0010_123_144_20220414_00368.jpg

LM Start	11.37	Rating **	M	Issue No.	144
LM End	11.37	Issue Type +	Ma	Location *	LS
Category	Earthen Levee			GPS Latitude/Longitude	
				Start	End
Item	Trim / Thin Trees			37.187792 °	37.187792 °
				-120.659454 °	-120.659454 °
DWR ID	DWR_NA0010_05_f_2018_144				
Comment Code					
T6 : Trees / Falling Tree.					
Inspector Comment					
Tree limbs on the levee slope should be trimmed to allow access.

View of tree limbs on levee slope. (Spring 2022)

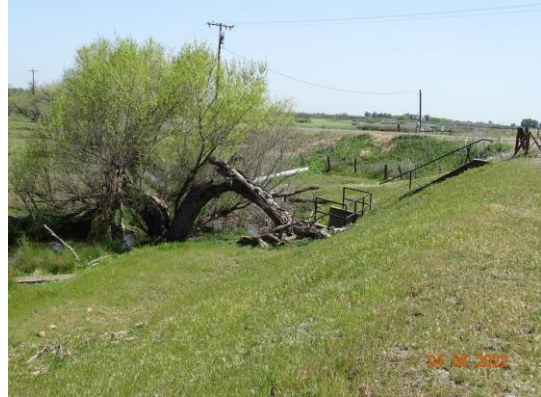
Photo 1 of 1 : SP_2022_NA0010_123_147_20220414_00369.jpg

LM Start	11.49	Rating **	U	Issue No.	147
LM End	11.49	Issue Type +	Ma	Location *	LS
Category	Earthen Levee			GPS Latitude/Longitude	
				Start	End
Item	Trim / Thin Trees			37.186482 °	37.186482 °
				-120.657935 °	-120.657935 °
DWR ID	DWR_NA0010_05_f_2021_147				
Comment Code					
T6 : Trees / Falling Tree.					
Inspector Comment					
Tree limbs are located on landside slope and toe.

Tree limbs on levee toe. (Spring 2022)

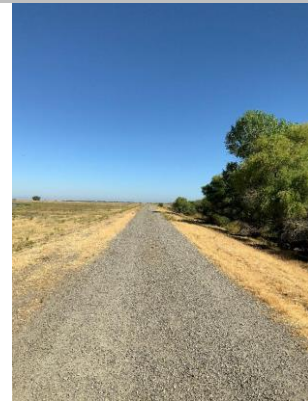
Photo 1 of 3 : UCIP_SP_2022_71012_103968.jpg

Comment Code						
Inspector Comment						
FS_ID:71012						
DS_ID:19768						
EP_NO: N/A						
Repair Type: Non-Urgent						
Crossing Status: Found						
UCIP Comments: 06/22/2021 The record has been upgraded from No Action Needed to Non-Urgent. Crossing appears to be in good condition. No permit was found authorizing this encroachment. CVFPB will need to review crossing to determine owner. The UCIP inspection was completed with GEI staff, H.Dunn. (P.Espinoza ? GEI)						
FIELD_STRUCT_DESC: [Deadman Drain] 1 of 2: 48-inch corrugated metal gravity drainage pipe (CMP) through the levee, 16.0 feet below the crown. Slide gate in a 60-inch CMP riser unit on the waterside (WS) slope. Concrete U-shaped headwall on each end. Stairs on the landside (LS) slope. [Additional Reference(s): DWR Levee Log, 2002, (HLM 11.45). USACE San Joaquin O&M Manual, Unit No. 601, Part No. 1, 1967, Amended in 1978, Revised 20 June 1985, (HLM 11.48). DWR As-Built Specification No. 61-01, Sheet No. 53, 7 March 1961, (HLM 11.48)].

View from levee crown.

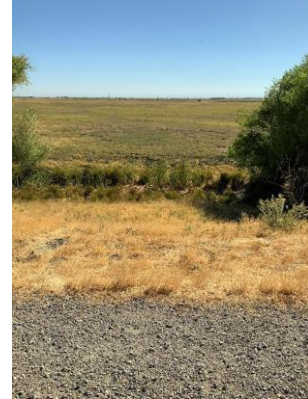
Photo 2 of 3 : UCIP_SP_2022_71012_103970.jpg

LS view of slope from levee crown.

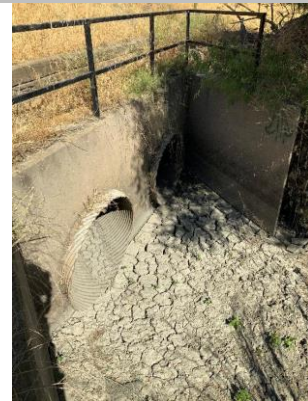
Photo 3 of 3 : UCIP_SP_2022_71012_103973.jpg

LS view: concrete headwall and inlet pipe visible on slope.

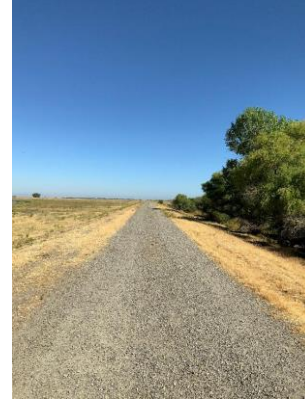
Photo 1 of 3 : UCIP_SP_2022_71013_104487.jpg

Comment Code						
Inspector Comment						
FS_ID:71013 DS_ID:19734 EP_NO: N/A Repair Type: Non-Urgent Crossing Status: Found UCIP Comments: 06/22/2021 The record has been upgraded from No Action Needed to Non-Urgent. Crossing appears to be in good condition. No permit was found authorizing this encroachment. CVFPB will need to review crossing to determine owner. The UCIP inspection was completed with GEI staff, P. Espinoza. (H. Dunn ? GEI) FIELD_STRUCT_DESC: [Deadman Drain] 2 of 2: 48-inch corrugated metal gravity drainage pipe (CMP) through the levee, 16.0 feet below the crown. Slide gate in a 60-inch CMP riser unit on the waterside (WS) slope. Concrete U-shaped headwall on each end. Stairs on the landside (LS) slope. [Additional Reference(s): DWR Levee Log, 2002, (HLM 11.45). USACE San Joaquin O&M Manual, Unit No. 601, Part No. 1, 1967, Amended in 1978, Revised 20 June 1985, (HLM 11.48). DWR As-Built Specification No. 61-01, Sheet No. 53, 7 March 1961, (HLM 11.48)]. FS Date: 6/22/2021

Levee crown.

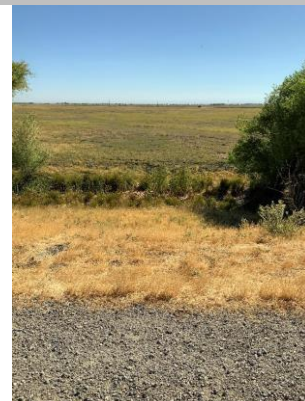
Photo 2 of 3 : UCIP_SP_2022_71013_104489.jpg

LS view: Toe from crown.

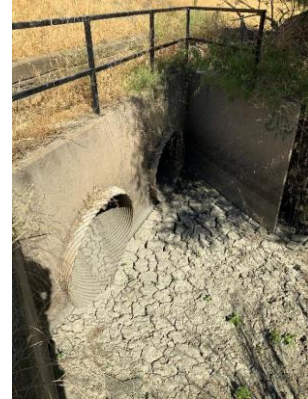
Photo 3 of 3 : UCIP_SP_2022_71013_104486.jpg

LS view: Closeup of inlet at toe.

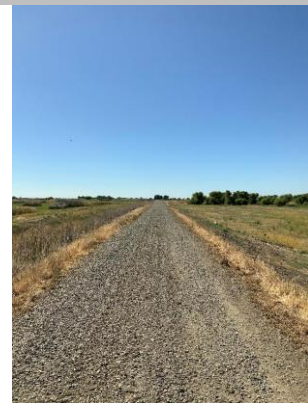
Photo 1 of 3 : UCIP_SP_2022_71015_103975.jpg

FS_ID:71015
DS_ID:19704
EP_NO: N/A
Repair Type: Urgent
Crossing Status: Found
UCIP Comments: 06/22/2021 The record has been upgraded from No Action Needed to Urgent. DWR DMP internal inspection has found pipe integrity issues. LOF of crossing is greater than or equal to 5 and less than 6. Crossing will be monitored until funding becomes available to address the issues. Limited inspection of inlet pipe due to dense vegetation; removal recommended. No permit was found authorizing this encroachment. CVFPB will need to review crossing to determine owner. The UCIP inspection was completed with GEI staff, H.Dunn. (P.Espinoza ? GEI)
FIELD_STRUCT_DESC: 24-inch corrugated metal gravity drainage pipe (CMP) through the levee, 11.8 feet below the crown. Flap gate on the waterside (WS) end. Concrete headwall on the landside (LS) end. Concrete saddle and apron on the WS end. [Additional Reference(s): DWR Levee Log, 2002, (HLM 11.60). USACE San Joaquin O&M Manual, Unit No. 601, Part No. 1, 1967, Amended in 1978, Revised 20 June 1985, (HLM 11.63). DWR As-Built Specification No. 61-01, Sheet No. 53, 7 March 1961, (HLM 11.63)].

View of levee crown.

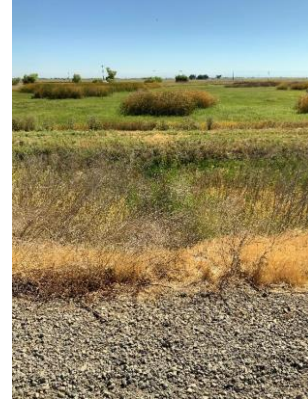
Photo 2 of 3 : UCIP_SP_2022_71015_103977.jpg

LS view: slope from crown.

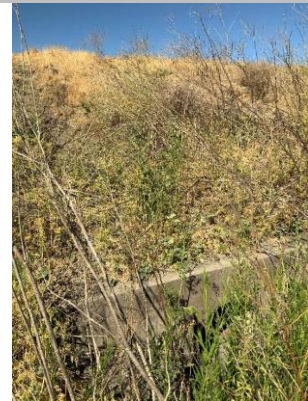
Photo 3 of 3 : UCIP_SP_2022_71015_103980.jpg

LS view: concrete headwall and inlet pipe at toe. Slope visible in background.

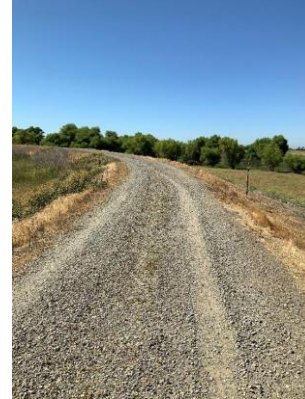
Photo 1 of 3 : UCIP_SP_2022_71016_103982.jpg

Comment Code					
Inspector Comment					
FS_ID:71016 DS_ID:19705 EP_NO: N/A Repair Type: Urgent Crossing Status: Found UCIP Comments: 06/22/2021 The record has been upgraded from No Action Needed to Urgent. DWR DMP internal inspection has found pipe integrity issues. LOF of crossing is between 4.1 and 5. Crossing will be monitored until funding becomes available for rehabilitation. Limited inspection of LS due to dense vegetation; recommend removal. Erosion around concrete headwall on WS, at least 1 foot in depth. No permit was found authorizing this encroachment. CVFPB will need to review crossing to determine owner. The UCIP inspection was completed with GEI staff, H.Dunn. (P.Espinoza ? GEI) FIELD_STRUCT_DESC: 24-inch corrugated metal gravity drainage pipe (CMP) through the levee, 12.5 feet below the crown. Flap gate on the waterside (WS) end. Concrete headwall on the landside (LS) end. Concrete saddle and apron on the WS end. Flashboard attachment on the LS end. [Additional Reference(s): DWR Levee Log, 2002, (HLM 11.98). USACE San Joaquin O&M Manual, Unit No. 601, Part No. 1, 1967, Amended in 1978, Revised 20 June 1985, (HLM 11.99). DWR As-Built Specification No. 61-01, Sheet No. 54, 7 March 1961, (HLM 11.99)]. FS Date: 6/22/2021

View of levee crown.

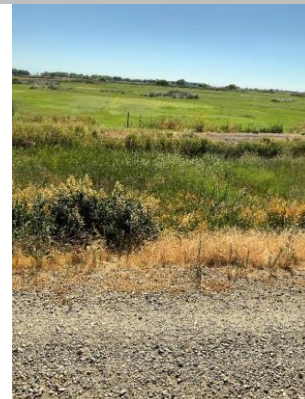
Photo 2 of 3 : UCIP_SP_2022_71016_103983.jpg

LS view: slope from crown.

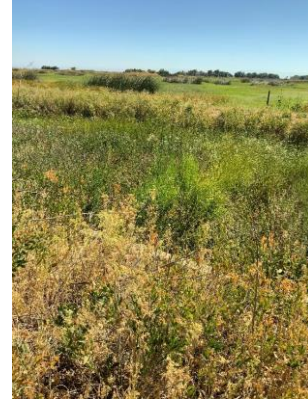
Photo 3 of 3 : UCIP_SP_2022_71016_103989.jpg

LS view: concrete headwall visible at toe.

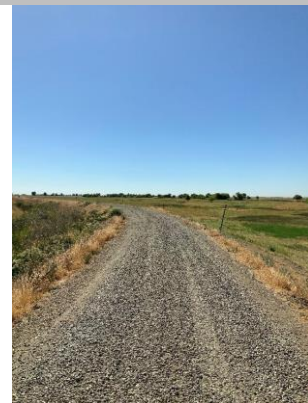
Photo 1 of 3 : UCIP_SP_2022_71017_103999.jpg

FS_ID:71017
 DS_ID:19706
 EP_NO: N/A
 Repair Type: Urgent
 Crossing Status: Found
 UCIP Comments: 06/22/2021 The record has been upgraded from No Action Needed to Urgent. DWR DMP internal inspection has found pipe integrity issues. LOF of crossing is between 5 and 6. Crossing will be monitored until funding becomes available to address the issues. Erosion around concrete headwall on WS, at least 1 foot in length. Limited inspection of LS due to vegetation and sediment; recommend removal. No permit was found authorizing this encroachment. CVFPB will need to review crossing to determine owner. The UCIP inspection was completed with GEI staff, H.Dunn. (P.Espinoza ? GEI)
 FIELD_STRUCT_DESC: 24-inch corrugated metal gravity drainage pipe (CMP) through the levee, 10.2 feet below the crown. Flap gate on the waterside (WS) end. Concrete headwall on the landside (LS) end. Concrete saddle and apron on the WS end. Flashboard attachment on the LS end. Pipe crosses levee at a 45-degree angle. [Additional Reference(s): DWR Levee Log, 2002, (HLM 12.38). USACE San Joaquin O&M Manual, Unit No. 601, Part No. 1, 1967, Amended in 1978, Revised 20 June 1985, (HLM 12.38). DWR As-Built Specification No. 61-01, Sheet No. 54, 7 March 1961, (HLM 12.38)].

View of levee crown.

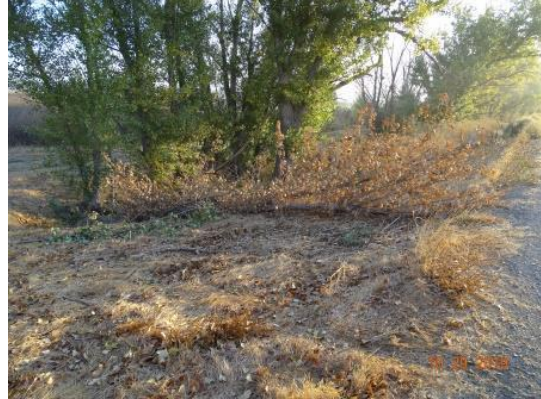
Photo 1 of 1 : SP_2022_NA0010_123_158_20220308_00049.jpg

LM Start	12.88	Rating **	M	Issue No.	158
LM End	12.88	Issue Type +	Ma	Location *	LS
Category	Earthen Levee			GPS Latitude/Longitude	
				Start	End
Item	Encroachments			37.175807 °	37.175807 °
				-120.641139 °	-120.641139 °
DWR ID	DWR_NA0010_05_f_2019_158				
Comment Code					
TR : Tree or limb					
Inspector Comment					
Tree limb on the landside slope should be removed.

View of downed tree limb on the landside slope. (Fall 2019)

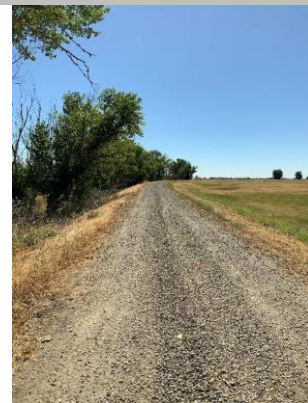
Photo 1 of 3 : UCIP_SP_2022_71018_103991.jpg

Comment Code					
Inspector Comment					
FS_ID:71018 DS_ID:19707 EP_NO: N/A Repair Type: Non-Urgent Crossing Status: Found UCIP Comments: 06/22/2021 The record remains Non-Urgent. DWR DMP internal inspection has found pipe integrity issues. LOF of crossing is between 4.1 and 5. Crossing will be monitored until funding becomes available for rehabilitation. Limited inspection of LS due to vegetation overgrowth; recommend removal. No permit was found authorizing this encroachment. CVFPB will need to review crossing to determine owner. The UCIP inspection was completed with GEI staff, H.Dunn. (P.Espinoza ? GEI) 04/22/2014 Sediment buildup in pipe visible from landward side--recommend contacting owner to clear pipe. (W. Wylie - DWR UCIP) FIELD_STRUCT_DESC: 24-inch corrugated metal gravity drainage pipe (CMP) through the levee, 10.2 feet below the crown. Concrete headwall on the landside (LS) end with flashboards. Concrete saddle and apron on the waterside (WS) end with a flap gate. Metal screen at the LS toe inlet. [Additional Reference(s): DWR Levee Log, 2002, (HLM 12.87). USACE San Joaquin O&M Manual, Unit No. 601, Part No. 1, 1967, Amended in 1978, Revised 20 June 1985, (HLM 12.87). DWR As-Built Specification No. 61-01, Sheet No. 54, 7 March 1961, (HLM 12.87)]. FS Date: 6/22/2021

View of levee crown.

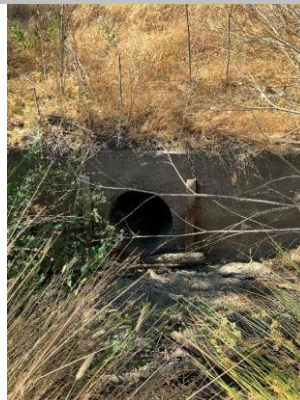
Photo 2 of 3 : UCIP_SP_2022_71018_103998.jpg

LS view: concrete headwall and inlet pipe at toe.

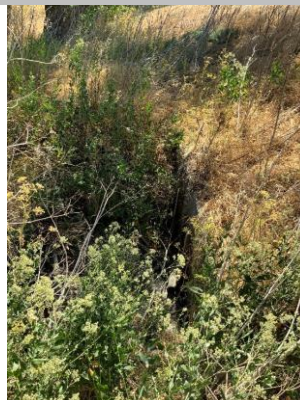
Photo 3 of 3 : UCIP_SP_2022_71018_103996.jpg

LS view: concrete headwall and inlet pipe.

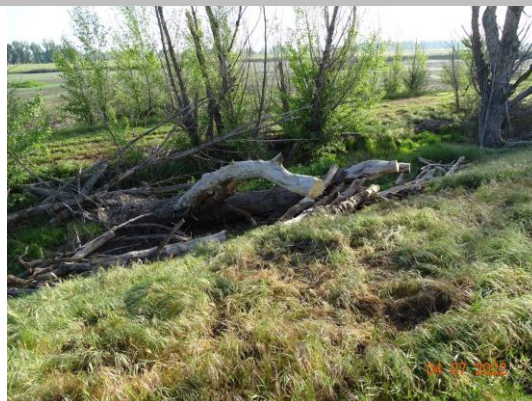
Photo 1 of 1 : SP_2022_NA0010_123_2_20220414_00370.jpg

LM Start	13.01	Rating **	U	Issue No.	2
LM End	13.01	Issue Type +	Ma	Location *	LS
Category	Earthen Levee			GPS Latitude/Longitude	
				Start	End
Item	Encroachments			37.175576 °	37.175576 °
				-120.638755 °	-120.638755 °
DWR ID	DWR_NA0010_05_s_2016_2				
Comment Code					
TR : Tree or limb					
Inspector Comment					
There are several downed trees on landside toe.

Looking west at down tree at landward toe. (Spring 2022)

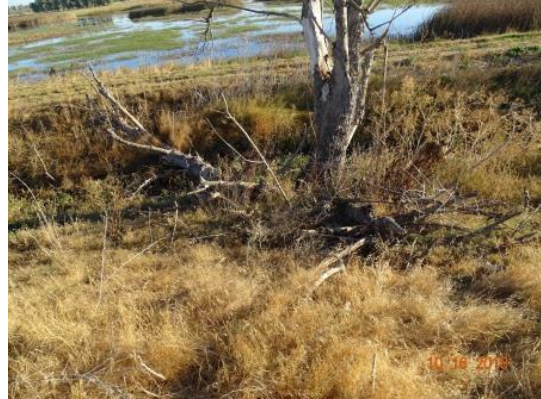
Photo 1 of 1 : SP_2022_NA0010_123_150_20220308_00044.jpg

LM Start	13.05	Rating **	M	Issue No.	150
LM End	13.05	Issue Type +	Ma	Location *	LS
Category	Earthen Levee			GPS Latitude/Longitude	
				Start	End
Item	Encroachments			37.175314 °	37.175314 °
				-120.638034 °	-120.638034 °
DWR ID	DWR_NA0010_05_f _ 2018_150				
Comment Code					
TR : Tree or limb					
Inspector Comment					
There are tree trimmings on the levee slope and toe.

Tree trimmings on landside slope and toe. (Fall 2018)

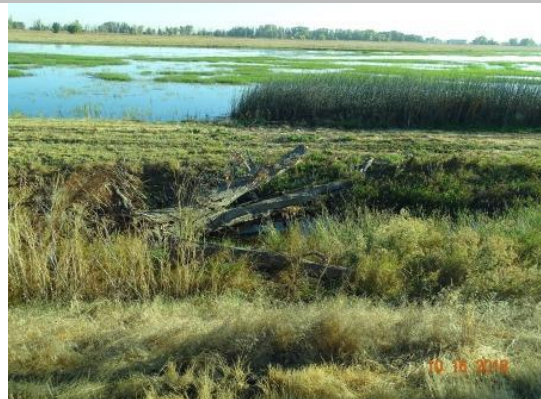
Photo 1 of 1 : SP_2022_NA0010_123_152_20220308_00045.jpg

LM Start	13.15	Rating **	M	Issue No.	152
LM End	13.15	Issue Type +	Ma	Location *	LS
Category	Earthen Levee			GPS Latitude/Longitude	
				Start	End
Item	Encroachments			37.174444 °	37.174444 °
				-120.636589 °	-120.636589 °
DWR ID	DWR_NA0010_05_f_2018_152				
Comment Code					
TR : Tree or limb					
Inspector Comment					
There is a tree trunk on landside toe.

Tree trunk on landside toe. (Fall 2018)

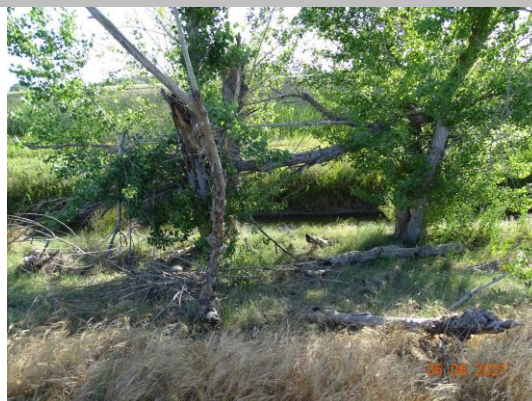
Photo 1 of 1 : SP_2022_NA0010_123_112_20220308_00016.jpg

LM Start	13.37	Rating **	U	Issue No.	112
LM End	13.37	Issue Type +	Ma	Location *	LS
Category	Earthen Levee			GPS Latitude/Longitude	
				Start	End
Item	Encroachments			37.172033 °	37.172033 °
				-120.634005 °	-120.634005 °
DWR ID	DWR_NA0010_05_s_2021_112				
Comment Code					
TR : Tree or limb					
Inspector Comment

View of tree limbs on the landside toe and slope. (Spring 2021)

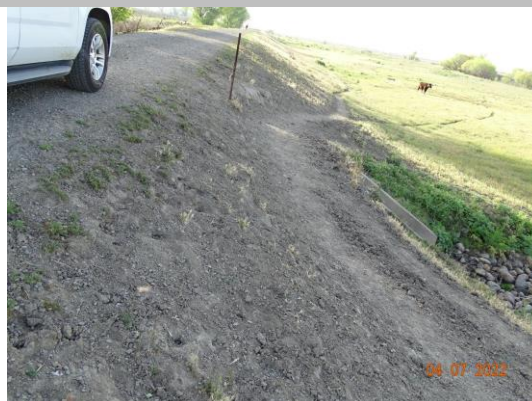
Photo 1 of 1 : SP_2022_NA0010_123_170_20220414_00371.jpg

LM Start	13.42	Rating **	U	Issue No.	170
LM End	13.42	Issue Type +	Ma	Location *	WS
Category	Earthen Levee			GPS Latitude/Longitude	
				Start	End
Item	Erosion / Livestock			37.171545 °	37.171545 °
				-120.633480 °	-120.633480 °
DWR ID	DWR_NA0010_05_s_2022_170				
Comment Code					
E4 : Repair the levee slope damaged by livestock and prevent large animal access.					
Inspector Comment

Erosion from livestock on the waterside slope around the pipe crossing. (Spring 2022)

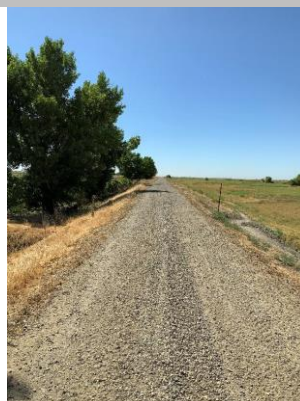
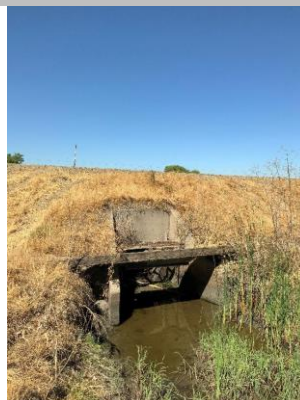
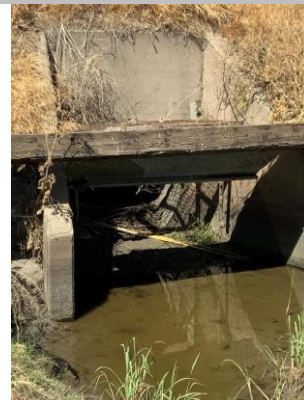
Photo 1 of 3 : UCIP_SP_2022_71019_104009.jpg

Comment Code						
Inspector Comment						
FS_ID:71019 DS_ID:19708 EP_NO: N/A Repair Type: Non-Urgent Crossing Status: Found UCIP Comments: 06/22/2021 The record remains Non-Urgent. Limited inspection of LS due to water around the inlet at the time of survey. LS inlet has sediment buildup, recommend removal. No permit was found authorizing this encroachment. CVFPB will need to review crossing to determine owner. The UCIP inspection was completed with GEI staff, H.Dunn. (P.Espinoza ? GEI) 04/22/2014 Some erosion around headwall on the WS toe and there are animal burrows on both slopes. (W. Wylie - DWR UCIP) FIELD_STRUCT_DESC: 48-inch corrugated metal gravity drainage pipe (CMP) through the levee, 10.0 feet below the crown. Flap gate on the waterside (WS) end. Flashboard attachment in a concrete U-shaped headwall on the landside (LS) end. Concrete U-shaped headwall on the WS end. [Additional Reference(s): DWR Levee Log, 2002, (HLM 13.40). USACE San Joaquin O&M Manual, Unit No. 601, Part No. 1, 1967, Amended in 1978, Revised 20 June 1985, (HLM 13.40)]. FS Date: 6/22/2021

View of levee crown.

LS view from toe: concrete headwall and inlet pipe. Slope visible in background.

LS view from toe: closeup of concrete headwall and inlet.

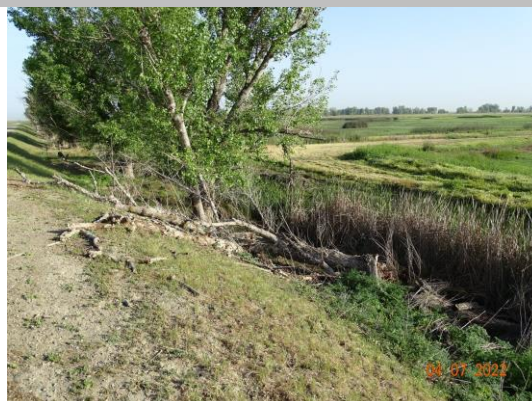
Photo 1 of 1 : SP_2022_NA0010_123_209_20220414_00372.jpg

LM Start	13.44	Rating **	U	Issue No.	209
LM End	13.44	Issue Type +	Ma	Location *	LS
Category	Earthen Levee			GPS Latitude/Longitude	
				Start	End
Item	Encroachments			37.171249 °	37.171249 °
				-120.633157 °	-120.633157 °
DWR ID	DWR_NA0010_05_s_2020_209				
Comment Code					
TR : Tree or limb					
Inspector Comment					
Dead tree should be removed before it can damage the levee.

Dead tree falling over on the landside toe. (Spring 2022)

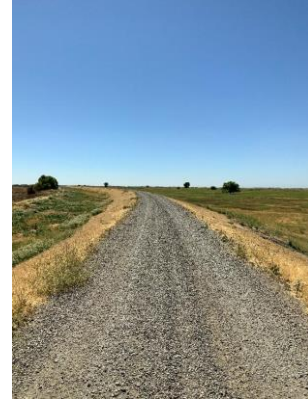
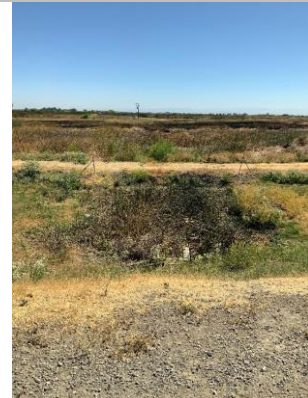
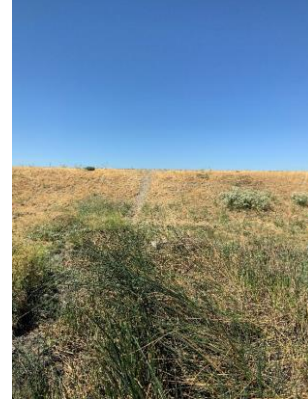
Photo 1 of 3 : UCIP_SP_2022_71023_104019.jpg

Comment Code					
Inspector Comment					
FS_ID:71023 DS_ID:19710 EP_NO: N/A Repair Type: Urgent Crossing Status: Found UCIP Comments: 06/22/2021 The record has been upgraded from No Action Needed to Urgent. Subsidence along the WS slope that is at least 1 foot in length. Limited inspection of LS due to vegetation; recommend removal. No permit was found authorizing this encroachment. CVFPB will need to review crossing to determine owner. The UCIP inspection was completed with GEI staff, H.Dunn. (P.Espinoza ? GEI) FIELD_STRUCT_DESC: 24-inch corrugated metal gravity drainage pipe (CMP) through the levee, 12.4 feet below the crown. Flap gate on the waterside (WS) end. Concrete headwall on each end. [Additional Reference(s): DWR Levee Log, 2002, (HLM 13.84). USACE San Joaquin O&M Manual, Unit No. 601, Part No. 1, 1967, Amended in 1978, Revised 20 June 1985, (HLM 13.83). DWR As-Built Specification No. 61-01, Sheet No. 55, 7 March 1961, (HLM 13.83)]. FS Date: 6/22/2021

View of levee crown.

LS view: slope to toe from crown.

LS view of slope from toe.

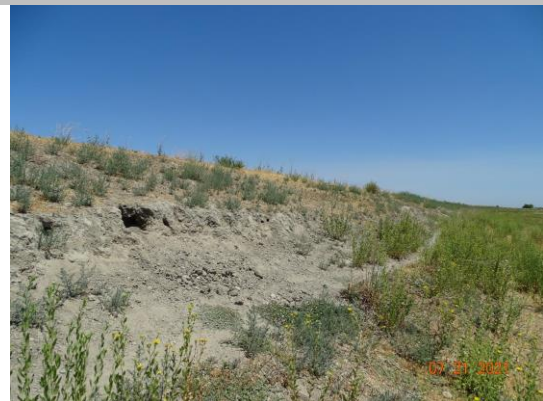
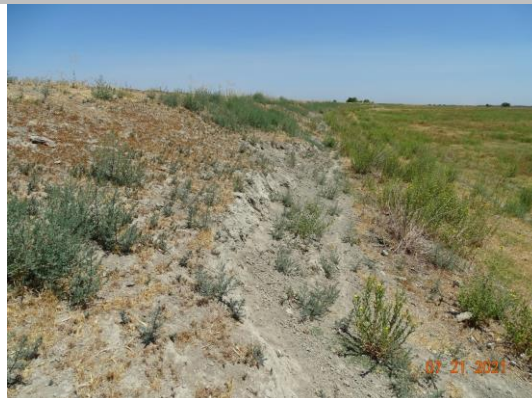
Photo 1 of 3 : SP_2022_NA0010_123_3_20220308_00004.jpg

07/21/2021: This site was discovered during the DWR Spring 2021 Levee Inspections. There is a series of erosion pockets along the lower levee slope and toe, ranging from 3 ft in length to 15 ft and 2 ft to 7 ft in scarp height. There are lots of rodent holes on the entire levee slope.

7/21/2021: View of an erosion pocket and large animal hole looking upstream.

7/21/2021: Close-up view of the erosion near the upstream end.
