**Flood Control Project Maintenance
Levee Inspections**

Maintenance Issue Types Only, Levee Inspection Report By Mile - Spring 2022

Lower San Joaquin Levee District

Waterway	Bank	Unit Miles	Inspection Start/End	Inspector
Unit No. 01 San Joaquin River	Right	22.52	04/05/2022 04/05/2022	Corey Fujitani

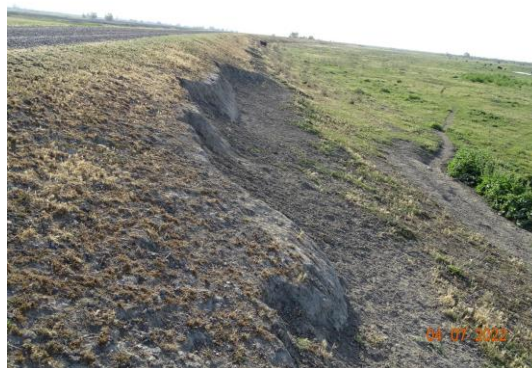
Photo 1 of 1 : SP_2022_NA0010_123_119_20220414_00373.jpg

LM Start	14.42	Rating **	U	Issue No.	119
LM End	14.49	Issue Type +	Ma	Location *	WS
Category	Earthen Levee			GPS Latitude/Longitude	
				Start	End
Item	Erosion / Bank Caving			37.162949 °	37.162540 °
				-120.619138 °	-120.618091 °
DWR ID	DWR_NA0010_05_s_2021_119				
Comment Code					
E1 : Note and monitor erosion site.					
Inspector Comment					
Slope erosion on the waterside slope. Possibly caused by livestock.

Looking upstream along the waterside slope at erosion spots. (Spring 2022)

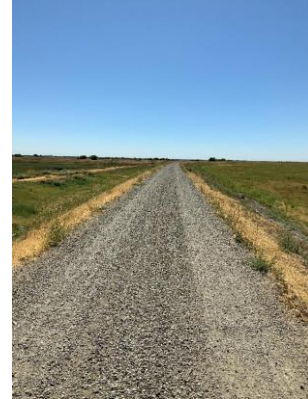
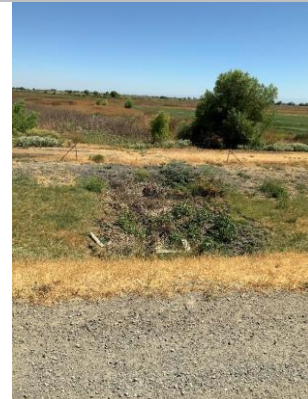
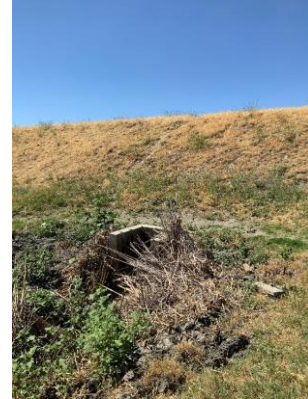
Photo 1 of 3 : UCIP_SP_2022_71024_104028.jpg

Comment Code						
Inspector Comment						
FS_ID:71024 DS_ID:19711 EP_NO: N/A Repair Type: Non-Urgent Crossing Status: Found UCIP Comments: 06/22/2021 The record has been upgraded from No Action Needed to Non-Urgent. Dense vegetation on LS; recommend removal. No permit was found authorizing this encroachment. CVFPB will need to review crossing to determine owner. The UCIP inspection was completed with GEI staff, H.Dunn. (P.Espinoza ? GEI) FIELD_STRUCT_DESC: 24-inch corrugated metal gravity drainage pipe (CMP) through the levee, 12.5 feet below the crown. Flap gate on the waterside (WS) end. Concrete headwall on each end. Concrete weir inlet structure on the landside (LS) toe. [Additional Reference(s): DWR Levee Log, 2002, (HLM 14.44). USACE San Joaquin O&M Manual, Unit No. 601, Part No. 1, 1967, Amended in 1978, Revised 20 June 1985, (HLM 14.44)] FS Date: 6/22/2021

View from levee crown.

LS view of slope to toe from crown.

LS view of slope from toe: concrete headwall visible in background.

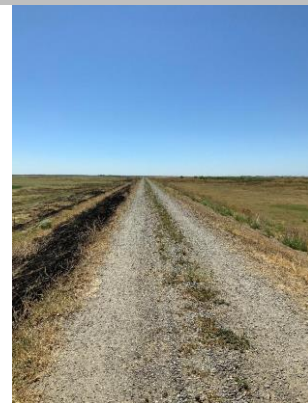
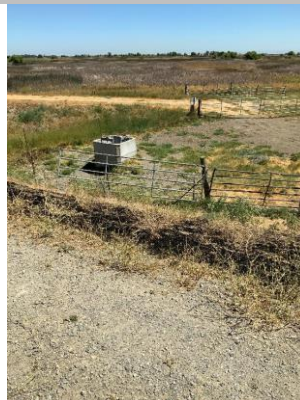
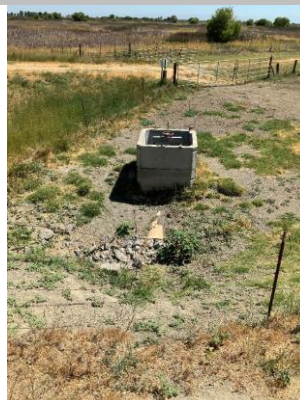
Photo 1 of 3 : UCIP_SP_2022_71025_104045.jpg

View from levee crown.

Comment Code					
Inspector Comment					
FS_ID:71025 DS_ID:19712 EP_NO: N/A Repair Type: Non-Urgent Crossing Status: Found UCIP Comments: 06/22/2021 The record remains Non-Urgent. Limited inspection on LS due to barbed wire and access issues. Build up of sediment at WS outlet pipe and LS inlet pipe; recommend removal. Some erosion along the WS slope, less than 1 foot. No permit was found authorizing this encroachment. CVFPB will need to review crossing to determine owner. The UCIP inspection was completed with GEI staff, H.Dunn. (P.Espinoza ? GEI) 04/23/2014 Minor erosion at headwall on WS toe. (W. Wylie - DWR UCIP) FIELD_STRUCT_DESC: 36-inch corrugated metal gravity drainage pipe (CMP) through the levee, 11.9 feet below the crown. Flap gate on the waterside (WS) end. Concrete headwall on each end. [Additional Reference(s): DWR Levee Log, 2002, (HLM 15.08). USACE San Joaquin O&M Manual, Unit No. 601, Part No. 1, 1967, Amended in 1978, Revised 20 June 1985, (HLM 15.09)]. FS Date: 6/22/2021

LS view of slope to toe from crown. Headwall visible in background.

LS view: closeup of headwall and inlet at toe.

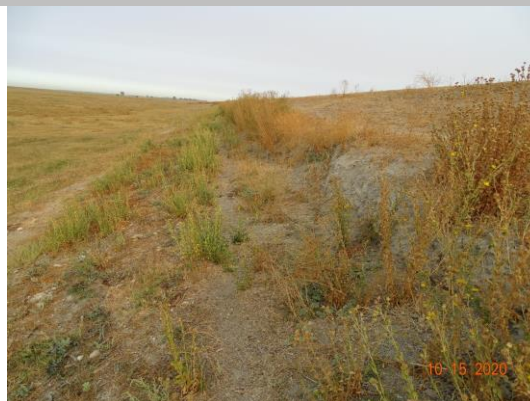
Photo 1 of 1 : SP_2022_NA0010_123_110_20220308_00015.jpg

LM Start	15.21	Rating **	M	Issue No.	110
LM End	15.26	Issue Type +	Ma	Location *	WS
Category	Earthen Levee			GPS Latitude/Longitude	
				Start	End
Item	Erosion / Bank Caving			37.155782 °	37.155337 °
				-120.608075 °	-120.607449 °
DWR ID	DWR_NA0010_05_f_2020_110				
Comment Code					
E1 : Note and monitor erosion site.					
Inspector Comment

Erosion along the waterside slope. (Fall 2020)

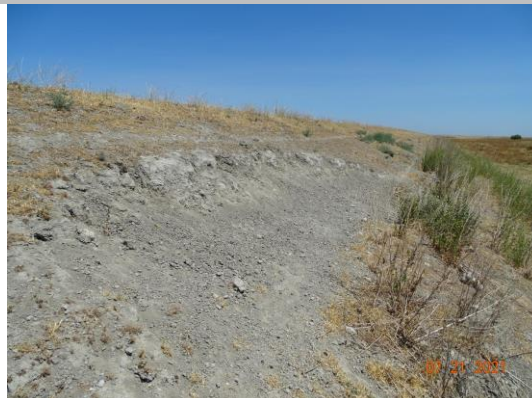
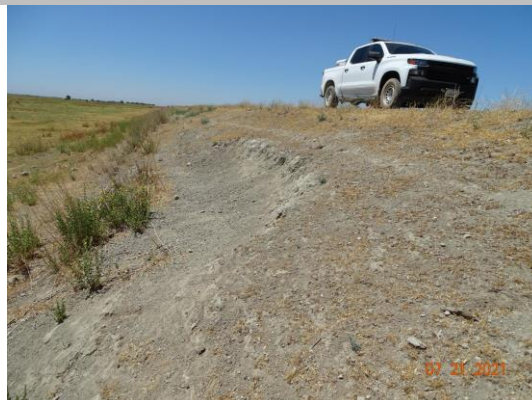
Photo 1 of 2 : SP_2022_NA0010_123_1_20220308_00001.jpg

07/21/2021: The erosion length was updated to 80 ft based on more accurate field measurements. Otherwise, no significant changes were observed since the previous inspection.

7/21/2021: View of the erosion looking upstream.

7/21/2021: View of the erosion looking downstream.

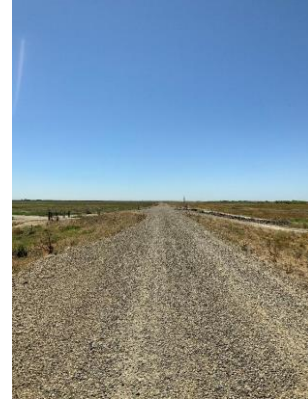
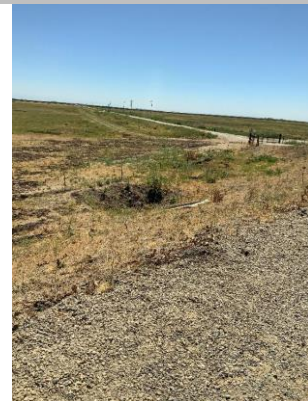
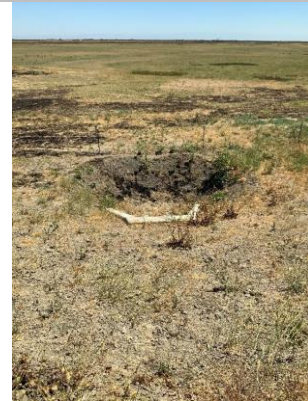
Photo 1 of 3 : UCIP_SP_2022_71026_104037.jpg

Comment Code					
Inspector Comment					
FS_ID:71026 DS_ID:19713 EP_NO: N/A Repair Type: Non-Urgent Crossing Status: Found UCIP Comments: 06/22/2021 The record remains Non-Urgent. Crossing appears to be in good condition. No permit was found authorizing this encroachment. CVFPB will need to review crossing to determine owner. The UCIP inspection was completed with GEI staff, H.Dunn. (P.Espinoza ? GEI) 04/23/2014 Sediment buildup in pipe visible from landward side--recommend contacting owner to clear pipe. (W. Wylie - DWR UCIP) FIELD_STRUCT_DESC: 24-inch corrugated metal gravity drainage pipe (CMP) through the levee, 11.0 feet below the crown. Flap gate on the waterside (WS) end. Concrete headwall on each end. [Additional Reference(s): DWR Levee Log, 2002, (HLM 15.74). USACE San Joaquin O&M Manual, Unit No. 601, Part No. 1, 1967, Amended in 1978, Revised 20 June 1985, (HLM 15.74)]. FS Date: 6/22/2021

View from levee crown.

LS view of slope to toe from crown.

LS view of slope to toe. Concrete headwall visible at toe.

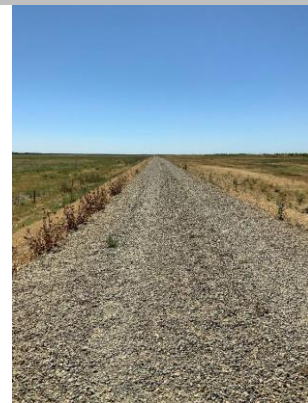
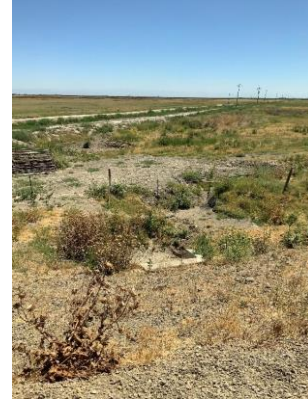
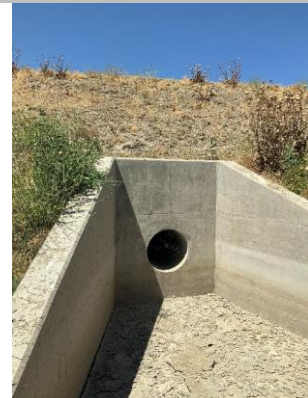
Photo 1 of 3 : UCIP_SP_2022_71028_104057.jpg

FS_ID:71028
DS_ID:19715
EP_NO: N/A
Repair Type: Non-Urgent
Crossing Status: Found
UCIP Comments: 06/22/2021 The record remains Non-Urgent.
Crossing appears to be in good condition. No permit was found authorizing this encroachment. CVFPB will need to review crossing to determine owner. The UCIP inspection was completed with GEI staff, H.Dunn. (P.Espinoza ? GEI) 04/23/2014 Excess vegetation at inlet on LS toe should be cleared. (W. Wylie - DWR UCIP)
FIELD_STRUCT_DESC: 24-inch corrugated metal gravity drainage pipe (CMP) through the levee, 12.0 feet below the crown. Flap gate on the waterside (WS) end. Concrete headwall on the landside (LS) end. Concrete saddle and apron on the WS end. [Additional Reference(s): DWR Levee Log, 2002, (HLM 15.79). USACE San Joaquin O&M Manual, Unit No. 601, Part No. 1, 1967, Amended in 1978, Revised 20 June 1985, (HLM 15.80)].
FS Date: 6/22/2021

View from levee crown.

LS view of slope to toe from crown. Concrete headwall visible at toe.

LS view from toe: concrete headwall and inlet. Slope visible in background.

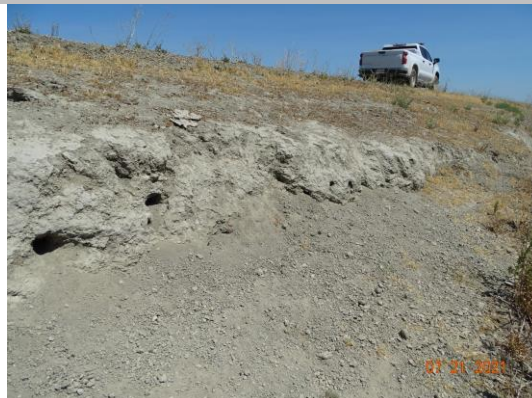
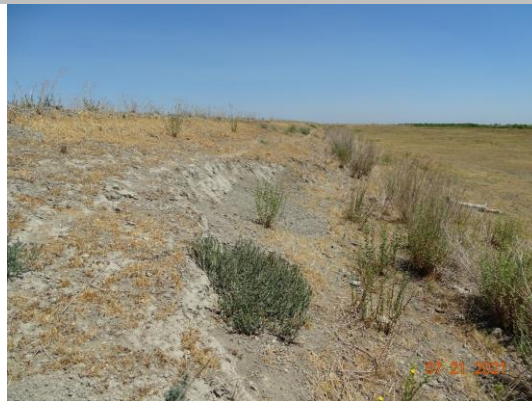
Photo 1 of 2 : SP_2022_NA0010_123_177_20220308_00061.jpg

Comment Code					
Inspector Comment					
Site ID: NA0010U05RM13.85 07/21/2021: From 2020 to present, no significant changes were observed during the annual survey. 08/19/2020: Due to ongoing construction both up and downstream, this site could not be accessed and only be viewed from the opposite bank across the bypass. Unable to determine if the conditions changed since the previous inspection. 09/10/2019: The erosion has become worse during the past 2 flood seasons. The erosion length has increased to approximately 200 ft from 55 ft. Signs of animal activity were observed. 09/20/2017: The erosion was discovered during spring levee inspection. The site is covered by dense vegetation and the measurements of the erosion are estimated.

7/21/2021: View of the erosion and rodent holes.

7/21/2021: View of the erosion looking upstream.

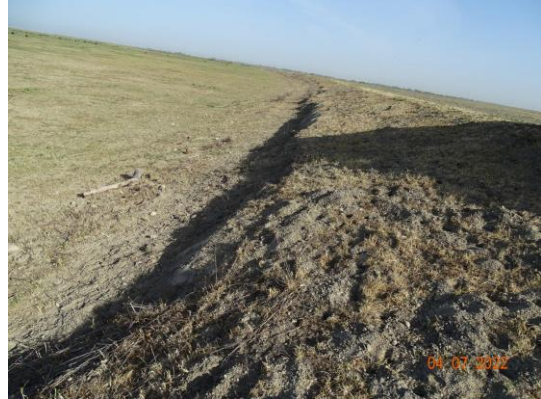
Photo 1 of 1 : SP_2022_NA0010_123_173_20220414_00374.jpg

LM Start	16.34	Rating **	M	Issue No.	173
LM End	16.34	Issue Type +	Ma	Location *	WS
Category	Earthen Levee			GPS Latitude/Longitude	
				Start	End
Item	Erosion / Livestock			37.143141 °	37.143141 °
				-120.595183 °	-120.595183 °
DWR ID	DWR_NA0010_05_s_2022_173				
Comment Code					
E4 : Repair the levee slope damaged by livestock and prevent large animal access.					
Inspector Comment

Looking downstream along the waterside slope at erosion from livestock activity. (Spring 2022)

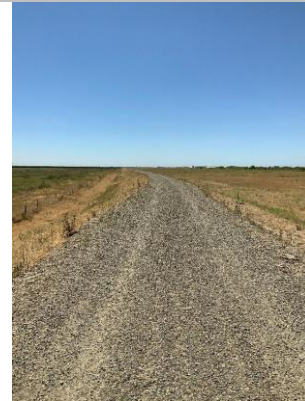
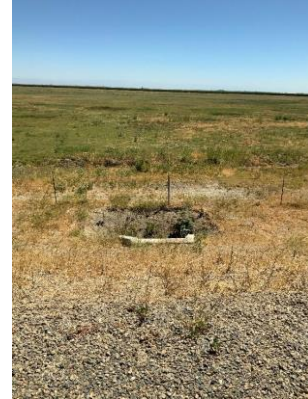
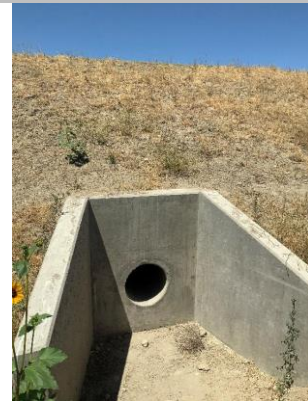
Comment Code						
Inspector Comment						
FS_ID:71029 DS_ID:19716 EP_NO: N/A Repair Type: Non-Urgent Crossing Status: Found UCIP Comments: 06/22/2021 The record remains Non-Urgent. Crossing appears to be in good condition. No permit was found authorizing this encroachment. CVFPB will need to review crossing to determine owner. The UCIP inspection was completed with GEI staff, H.Dunn. (P.Espinoza ? GEI) 04/23/2014 Pipe heavily silted on LS toe. (W. Wylie - DWR UCIP) FIELD_STRUCT_DESC: 24-inch corrugated metal gravity drainage pipe (CMP) through the levee, 10.5 feet below the crown. Flap gate on the waterside (WS) end. Concrete headwall on each end. [Additional Reference(s): DWR Levee Log, 2002, (HLM 16.66). USACE San Joaquin O&M Manual, Unit No. 601, Part No. 1, 1967, Amended in 1978, Revised 20 June 1985, (HLM 16.67). DWR As-Built Specification No. 61-01, Sheet No. 57, 7 March 1961, (HLM 16.67)]. FS Date: 6/22/2021

View from levee crown.

LS view of slope to toe from crown.

LS view from toe: concrete headwall and inlet. Slope visible in background.

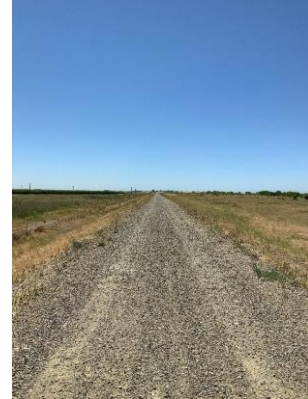
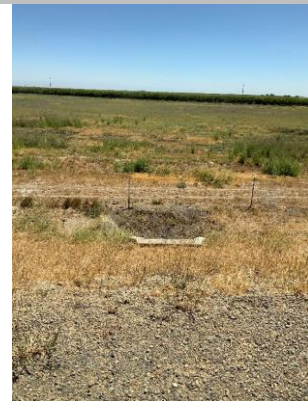
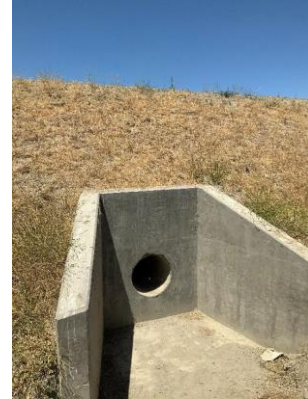
Comment Code					
Inspector Comment					
FS_ID:71030 DS_ID:19717 EP_NO: N/A Repair Type: Non-Urgent Crossing Status: Found UCIP Comments: 06/22/2021 The record remains Non-Urgent. Crossing appears to be in good condition. No permit was found authorizing this encroachment. CVFPB will need to review crossing to determine owner. The UCIP inspection was completed with GEI staff, H.Dunn. (P.Espinoza ? GEI) 04/23/2014 Sediment buildup in pipe visible from landward side--recommend contacting owner to clear pipe. (W. Wylie - DWR UCIP) FIELD_STRUCT_DESC: 24-inch corrugated metal gravity drainage pipe (CMP) through the levee, 12.0 feet below the crown. Flap gate on the waterside (WS) end. Concrete headwall on each end. [Additional Reference(s): DWR Levee Log, 2002, (HLM 17.21). USACE San Joaquin O&M Manual, Unit No. 601, Part No. 1, 1967, Amended in 1978, Revised 20 June 1985, (HLM 17.20)]. FS Date: 6/22/2021

View from levee crown.

LS view of slope to toe from crown.

LS view at toe: concrete headwall and inlet. Slope visible in background.

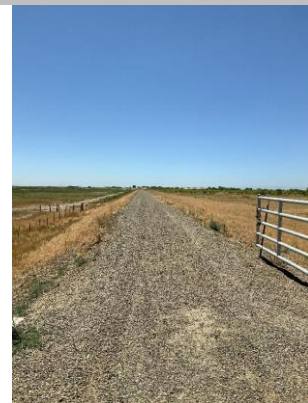
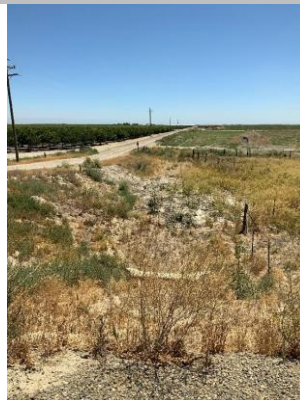
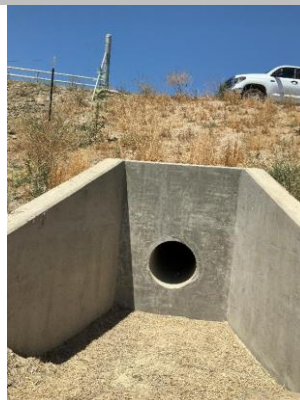
View from levee crown.

Comment Code					
Inspector Comment					
FS_ID:71031 DS_ID:19743 EP_NO: N/A Repair Type: Non-Urgent Crossing Status: Found UCIP Comments: 06/22/2021 The record remains Non-Urgent. Crossing appears to be in good condition. No permit was found authorizing this encroachment. CVFPB will need to review crossing to determine owner. The UCIP inspection was completed with GEI staff, H.Dunn. (P.Espinoza ? GEI) 04/23/2014 Sediment buildup in pipe visible from landward side--recommend contacting owner to clear pipe. (W. Wylie - DWR UCIP) FIELD_STRUCT_DESC: 24-inch corrugated metal gravity drainage pipe (CMP) through the levee, 9.8 feet below the crown. Flap gate on the waterside (WS) end. Concrete headwall on each end. [Additional Reference(s): DWR Levee Log, 2002, (HLM 17.52). USACE San Joaquin O&M Manual, Unit No. 601, Part No. 1, 1967, Amended in 1978, Revised 20 June 1985, (HLM 17.52). DWR As-Built Specification No. 61-01, Sheet No. 58, 7 March 1961, (HLM 17.52)]. FS Date: 6/22/2021

LS view of slope to toe from crown. Concrete headwall visible at toe.

LS view from toe: concrete headwall and inlet. Slope visible in background.

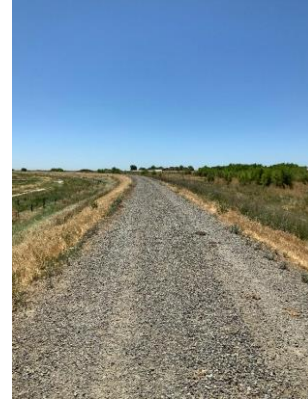
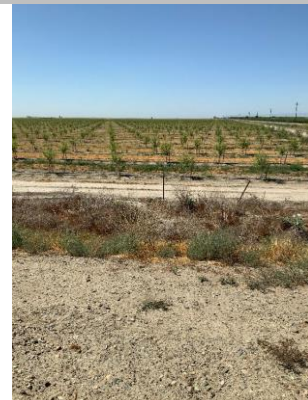
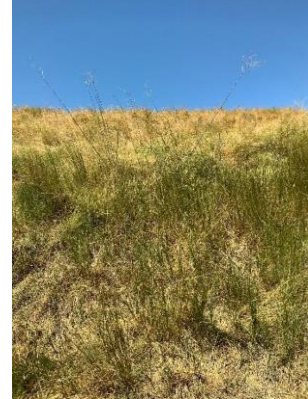
Comment Code						
Inspector Comment						
FS_ID:71033 DS_ID:19745 EP_NO: N/A Repair Type: Non-Urgent Crossing Status: Found UCIP Comments: 06/22/2021 The record remains Non-Urgent. Limited inspection of LS pipe inlet due to dense vegetation, recommend removal. No permit was found authorizing this encroachment. CVFPB will need to review crossing to determine owner. The UCIP inspection was completed with GEI staff, P. Espinoza. (H. Dunn ? GEI) 04/23/2014 Animal burrows in levee on both slopes. (W. Wylie - DWR UCIP) FIELD_STRUCT_DESC: 24-inch corrugated metal gravity drainage pipe (CMP) through the levee, 12.4 feet below the crown. Flap gate on the waterside (WS) end. Concrete headwall on each end. [Additional Reference(s): DWR Levee Log, 2002, (HLM 18.07). USACE San Joaquin O&M Manual, Unit No. 601, Part No. 1, 1967, Amended in 1978, Revised 20 June 1985, (HLM 18.07). DWR As-Built Specification No. 61-01, Sheet No. 58, 7 March 1961, (HLM 18.07)]. FS Date: 6/22/2021

Levee crown.

LS view: Toe from crown.

LS view: Slope from toe.

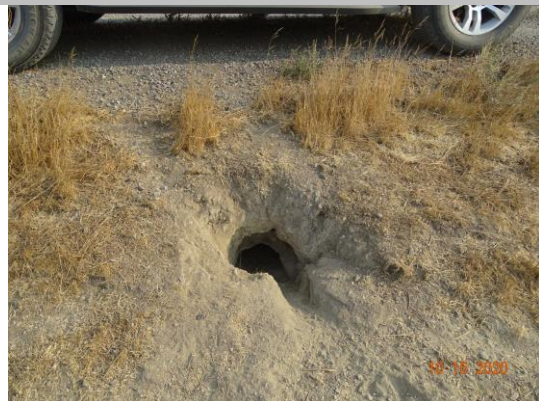
LM Start	18.50	Rating **	U	Issue No.	114
LM End	18.50	Issue Type +	Ma	Location *	WS
Category	Earthen Levee			GPS Latitude/Longitude	
				Start	End
Item	Animal Control			37.115960 °	37.115960 °
				-120.577170 °	-120.577170 °
DWR ID	DWR_NA0010_05_f_2020_114				
Comment Code					
A3 : No rodents visible, but rodent burrows visible; need to backfill and compact or grout burrows.					
Inspector Comment					
Burrow appears to connect to hole in landside shoulder.

View of rodent burrow in the waterside shoulder. (Fall 2020)

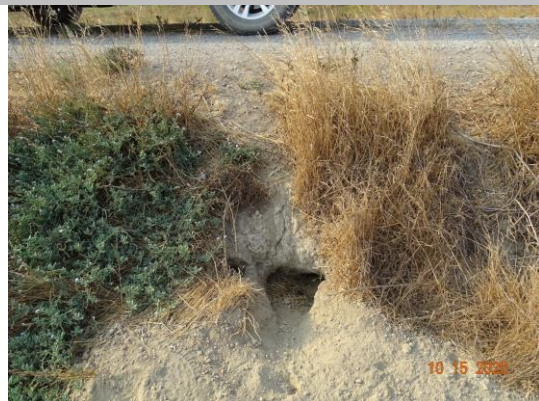
LM Start	18.50	Rating **	U	Issue No.	118
LM End	18.50	Issue Type +	Ma	Location *	LS
Category	Earthen Levee			GPS Latitude/Longitude	
				Start	End
Item	Animal Control			37.115960 °	37.115960 °
				-120.577170 °	-120.577170 °
DWR ID	DWR_NA0010_05_f_2020_118				
Comment Code					
A3 : No rodents visible, but rodent burrows visible; need to backfill and compact or grout burrows.					
Inspector Comment					
Burrow appears to connect to hole in waterside shoulder.

Large rodent hole in the landside shoulder. (Fall 2020)

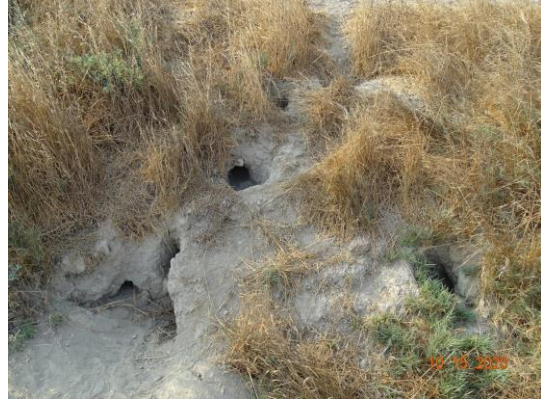
LM Start	18.62	Rating **	U	Issue No.	126
LM End	18.62	Issue Type +	Ma	Location *	LS
Category	Earthen Levee			GPS Latitude/Longitude	
				Start	End
Item	Animal Control			37.115481 °	37.115481 °
				-120.575126 °	-120.575126 °
DWR ID	DWR_NA0010_05_f_2020_126				
Comment Code					
A3 : No rodents visible, but rodent burrows visible; need to backfill and compact or grout burrows.					
Inspector Comment

Several large rodent holes observed at this location. (Fall 2020)

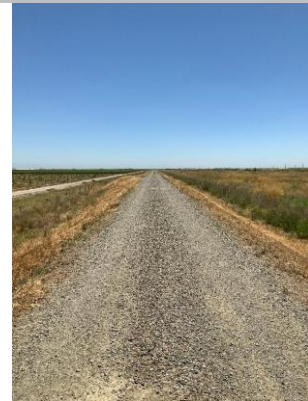
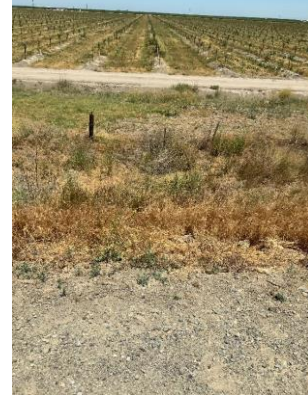
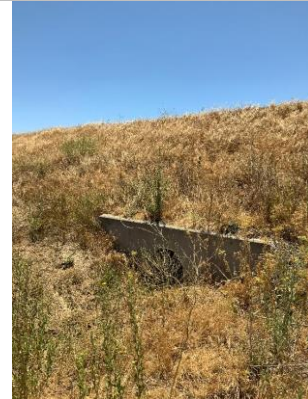
Comment Code						
Inspector Comment						
FS_ID:71034 DS_ID:19746 EP_NO: N/A Repair Type: Non-Urgent Crossing Status: Found UCIP Comments: 06/22/2021 The record remains Non-Urgent. Crossing appears to be in good condition. No permit was found authorizing this encroachment. CVFPB will need to review crossing to determine owner. The UCIP inspection was completed with GEI staff, P. Espinoza. (H. Dunn ? GEI) 04/23/2014 Dense vegetation limits the inspector's visibility to identify signs of pipe failure (leaks) along the landward slope. Recommend removing vegetation along pipe alignment to conduct proper inspection of structure. (W. Wylie - DWR UCIP) FIELD_STRUCT_DESC: 24-inch corrugated metal gravity drainage pipe (CMP) through the levee, 10.0 feet below the crown. Flap gate on the waterside (WS) end. Concrete headwall on the landside (LS) end. Concrete U-shaped headwall on the WS end. [Additional Reference(s): DWR Levee Log, 2002, (HLM 18.68). USACE San Joaquin O&M Manual, Unit No. 601, Part No. 1, 1967, Amended in 1978, Revised 20 June 1985, (HLM 18.68). DWR As-Built Specification No. 64-01, Sheet No. 3, 6 November 1963, (HLM 18.68)]. FS Date: 6/22/2021

Levee crown.

LS view: Toe from crown.

LS view: Slope and headwall from toe.

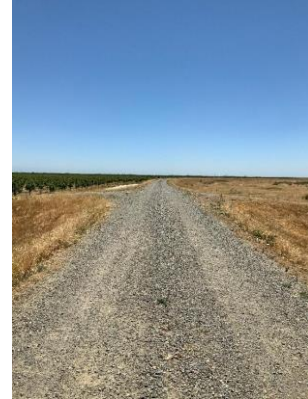
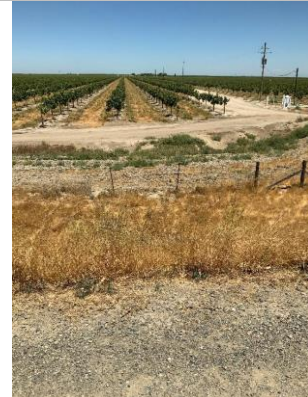
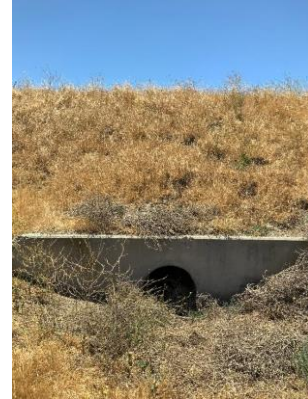
Comment Code						
Inspector Comment						
FS_ID:71035						
DS_ID:19747						
EP_NO: N/A						
Repair Type: Non-Urgent						
Crossing Status: Found						
UCIP Comments: 06/22/2021 The record remains Non-Urgent. Limited inspection due to LS inlet being covered by dense tumbleweeds, recommend removal. No permit was found authorizing this encroachment. CVFPB will need to review crossing to determine owner. The UCIP inspection was completed with GEI staff, P. Espinoza. (H. Dunn ? GEI) 04/23/2014 Sediment buildup in pipe visible from landward side--recommend contacting owner to clear pipe. (W. Wylie - DWR UCIP)						
FIELD_STRUCT_DESC: 24-inch corrugated metal gravity drainage pipe (CMP) through the levee, 10.0 feet below the crown. Flap gate on the waterside (WS) end. Concrete headwall on the landside (LS) end. Concrete U-shaped headwall on the WS end. [Additional Reference(s): DWR Levee Log, 2002, (HLM 19.13). USACE San Joaquin O&M Manual, Unit No. 601, Part No. 1, 1967, Amended in 1978, Revised 20 June 1985, (HLM 19.11). DWR As-Built Specification No. 64-01, Sheet No. 3, 6 November 1963, (HLM 19.11)].

Levee crown.

LS view: Toe from crown.

LS view: Slope and headwall at toe.

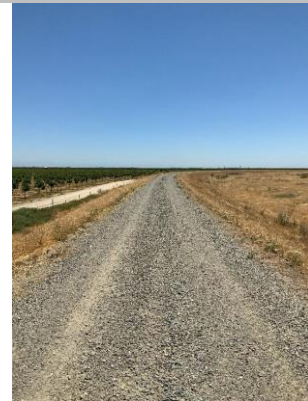
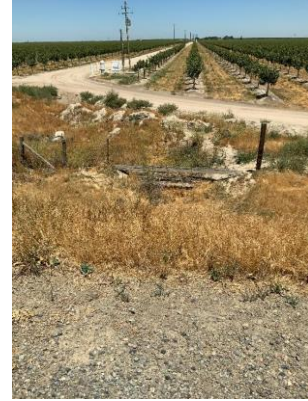
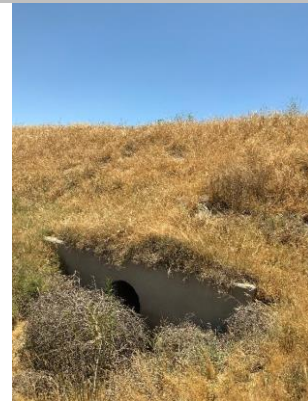
FS_ID:71036
 DS_ID:19776
 EP_NO: N/A
 Repair Type: Non-Urgent
 Crossing Status: Found
 UCIP Comments: 06/22/2021 The record has been upgraded from No Action Needed to Non-Urgent. Some tumbleweed buildup around LS inlet, recommend removal. No permit was found authorizing this encroachment. CVFPB will need to review crossing to determine owner. The UCIP inspection was completed with GEI staff, P. Espinoza. (H. Dunn ? GEI)
 FIELD_STRUCT_DESC: 24-inch corrugated metal gravity drainage pipe (CMP) through the levee, 10.3 feet below the crown. Flap gate on the waterside (WS) end. Concrete headwall on the landside (LS) end. Concrete U-shaped headwall on the WS end. [Additional Reference(s): DWR Levee Log, 2002, (HLM 19.15). USACE San Joaquin O&M Manual, Unit No. 601, Part No. 1, 1967, Amended in 1978, Revised 20 June 1985, (HLM 19.15). DWR As-Built Specification No. 64-01, Sheet No. 3, 6 November 1963, (HLM 19.15)].

Levee crown.

LS view: Toe from crown.

LS view: Headwall and slope from toe.

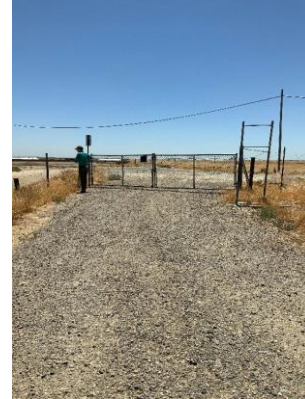
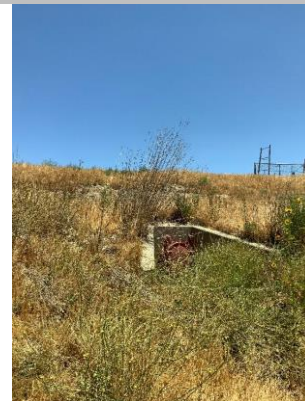
Comment Code						
Inspector Comment						
FS_ID:71037 DS_ID:19777 EP_NO: N/A Repair Type: Urgent Crossing Status: Found UCIP Comments: 06/22/2021 The record has been upgraded from Non-Urgent to Urgent. DWR DMP internal inspection has found pipe integrity issues. LOF of crossing is greater than or equal to 5 and less than 6. Crossing will be monitored until funding becomes available to address the issues. Limited inspection of LS inlet due to vegetation, recommend removal. No permit was found authorizing this encroachment. CVFPB will need to review crossing to determine owner. The UCIP inspection was completed with GEI staff, P. Espinoza. (H. Dunn ? GEI)04/23/2014 Sediment buildup in pipe visible from landward side-- recommend contacting owner to clear pipe. (W. Wylie - DWR UCIP) FIELD_STRUCT_DESC: 24-inch corrugated metal gravity drainage pipe (CMP) through the levee, 9.0 feet below the crown. Flap gate on the waterside (WS) end. Concrete headwall on the landside (LS) end. Concrete U-shaped headwall on the WS end. [Additional Reference(s): DWR Levee Log, 2002, (HLM 19.46). USACE San Joaquin O&M Manual, Unit No. 601, Part No. 1, 1967, Amended in 1978, Revised 20 June 1985, (HLM 19.46). DWR As-Built Specification No. 64-01, Sheet No. 3, 6 November 1963, (HLM 19.46)]. FS Date: 6/22/2021

Levee crown.

WS view: Headwall and slope from toe.

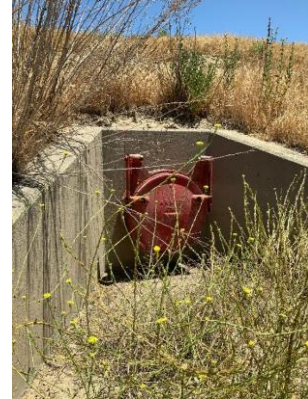
Photo 3 of 3 : UCIP_SP_2022_71037_104141.jpg

WS view: Closeup of flapgate at toe.

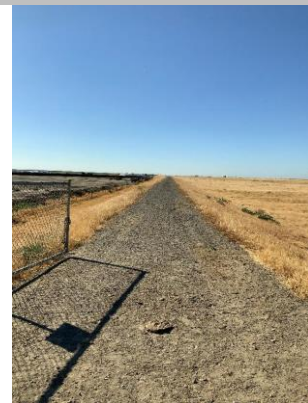
Photo 1 of 3 : UCIP_SP_2022_71039_104146.jpg

FS_ID:71039
DS_ID:19778
EP_NO: N/A
Repair Type: Non-Urgent
Crossing Status: Found
UCIP Comments: 06/23/2021 The record remains Non-Urgent. DWR DMP internal inspection has not found pipe integrity issues. LOF of crossing is less or equal to 4.0. Recommend next video inspection in 5 years. No permit was found authorizing this encroachment. CVFPB will need to review crossing to determine owner. The UCIP inspection was completed with GEI staff, P. Espinoza. (H. Dunn ? GEI) 04/23/2014 Dense vegetation limits the inspector's visibility to identify signs of pipe failure (leaks) along the landward slope. Recommend removing vegetation along pipe alignment to conduct proper inspection of structure. Sediment buildup in pipe visible from landward side-- recommend contacting owner to clear pipe. (W. Wylie - DWR UCIP) FIELD_STRUCT_DESC: 24-inch corrugated metal gravity drainage pipe (CMP) through the levee, 9.7 feet below the crown. Flap gate on the waterside (WS) end. Concrete headwall on the landside (LS) end. Concrete U-shaped headwall on the WS end. [Additional Reference(s): DWR Levee Log, 2002, (HLM 19.50). USACE San Joaquin O&M Manual, Unit No. 601, Part No. 1, 1967, Amended in 1978, Revised 20 June 1985, (HLM 19.50). DWR As-Built Specification No. 64-01, Sheet No. 3, 6 November 1963, (HLM 19.50)].

Levee crown.

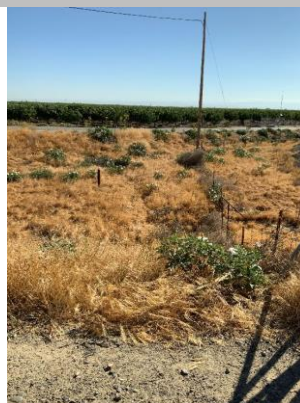
Photo 2 of 3 : UCIP_SP_2022_71039_104147.jpg

LS view: Toe from crown.

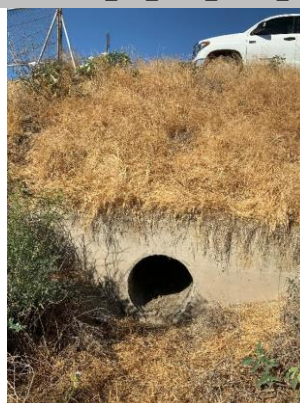
Photo 3 of 3 : UCIP_SP_2022_71039_104144.jpg

LS view: Headwall and slope at toe.

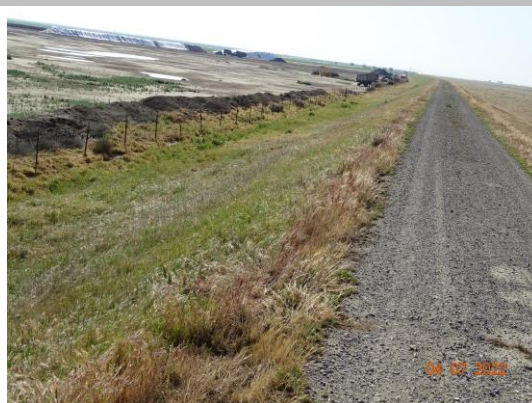
Photo 1 of 1 : SP_2022_NA0010_123_174_20220414_00375.jpg

LM Start	19.53	Rating **	M	Issue No.	174
LM End	23.25	Issue Type +	Ma	Location *	LS
Category	Earthen Levee			GPS Latitude/Longitude	
				Start	End
Item	Vegetation			37.112919 °	37.072942 °
				-120.559775 °	-120.516641 °
DWR ID	DWR_NA0010_05_s_2022_174				
Comment Code					
V1 : Control annual grass and weeds on the levee slopes and easements.					
Inspector Comment

View of the landside slope looking upstream. (Spring 2022)

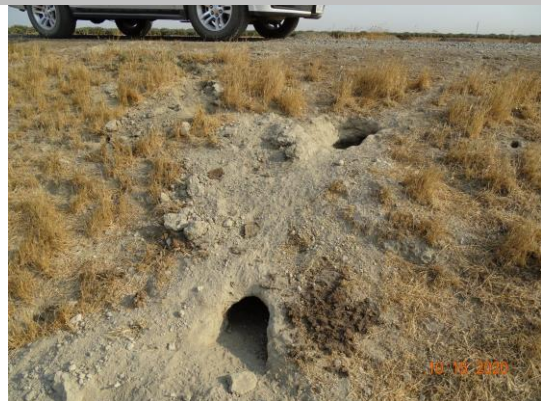
Photo 1 of 1 : SP_2022_NA0010_123_128_20220308_00028.jpg

LM Start	19.64	Rating **	U	Issue No.	128
LM End	19.64	Issue Type +	Ma	Location *	WS
Category	Earthen Levee			GPS Latitude/Longitude	
				Start	End
Item	Animal Control			37.111664 °	37.111664 °
				-120.558511 °	-120.558511 °
DWR ID	DWR_NA0010_05_f_2020_128				
Comment Code					
A3 : No rodents visible, but rodent burrows visible; need to backfill and compact or grout burrows.					
Inspector Comment

View of rodent activity on the waterside slope. (Fall 2020)

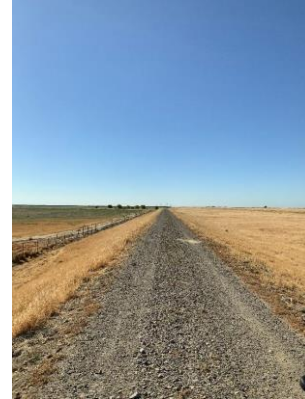
Photo 1 of 3 : UCIP_SP_2022_71040_104106.jpg

Comment Code						
Inspector Comment						
FS_ID:71040 DS_ID:19779 EP_NO: N/A Repair Type: Urgent Crossing Status: Found UCIP Comments: 06/23/2021 The record has been upgraded from No Action Needed to Urgent. DWR DMP internal inspection has found pipe integrity issues. LOF of crossing is greater than or equal to 5 and less than 6. Crossing will be monitored until funding becomes available to address the issues. WS flapgate has holes in it. LS pipe inlet has some minor debris buildup. No permit was found authorizing this encroachment. CVFPB will need to review crossing to determine owner. The UCIP inspection was completed with GEI staff, P. Espinoza. (H. Dunn ? GEI) FIELD_STRUCT_DESC: 24-inch corrugated metal gravity drainage pipe (CMP) through the levee, 10.3 feet below the crown. Flap gate on the waterside (WS) end. Concrete headwall on the landside (LS) end. Concrete U-shaped headwall on the WS end. [Additional Reference(s): DWR Levee Log, 2002, (HLM 19.83). USACE San Joaquin O&M Manual, Unit No. 601, Part No. 1, 1967, Amended in 1978, Revised 20 June 1985, (HLM 19.84). DWR As-Built Specification No. 64-01, Sheet No. 4, 6 November 1963, (HLM 19.84)]. FS Date: 6/23/2021

Levee crown.

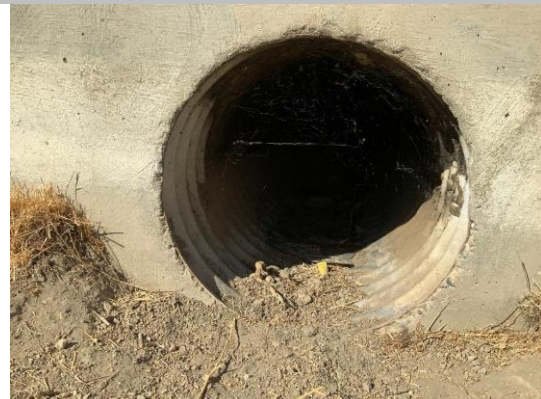
Photo 2 of 3 : UCIP_SP_2022_71040_104154.jpg

LS view: Closeup of pipe inlet at toe.

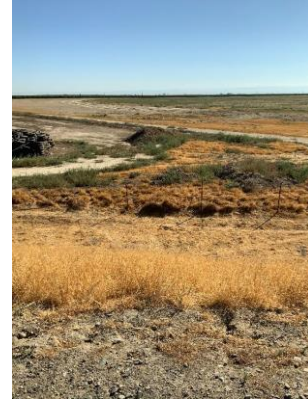
Photo 3 of 3 : UCIP_SP_2022_71040_104151.jpg

LS view: Toe from crown.

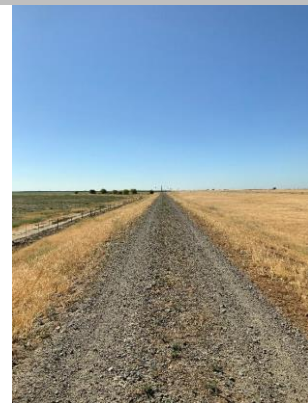
Photo 1 of 3 : UCIP_SP_2022_71041_104156.jpg

FS_ID:71041
 DS_ID:19780
 EP_NO: N/A
 Repair Type: Non-Urgent
 Crossing Status: Found
 UCIP Comments: 06/23/2021 The record has been upgraded from No Action Needed to Non-Urgent. DWR DMP internal inspection has not found pipe integrity issues. LOF of crossing is less or equal to 4.0. Recommend next video inspection in 5 years. No permit was found authorizing this encroachment. CVFPB will need to review crossing to determine owner. The UCIP inspection was completed with GEI staff, P. Espinoza. (H. Dunn ? GEI)
 FIELD_STRUCT_DESC: 36-inch corrugated metal gravity drainage pipe (CMP) through the levee, 9.8 feet below the crown. Flap gate on the waterside (WS) end. Concrete headwall on the landside (LS) end. Concrete U-shaped headwall on the WS end. [Additional Reference(s): DWR Levee Log, 2002, (HLM 19.92). USACE San Joaquin O&M Manual, Unit No. 601, Part No. 1, 1967, Amended in 1978, Revised 20 June 1985, (HLM 19.92). DWR As-Built Specification No. 64-01, Sheet No. 4, 6 November 1963, (HLM 19.92)].

Levee crown.

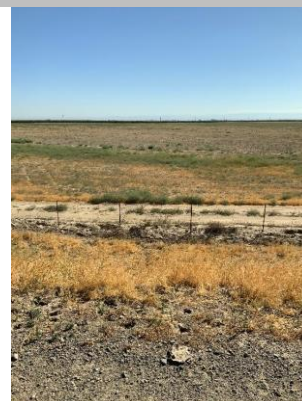
Photo 2 of 3 : UCIP_SP_2022_71041_104157.jpg

LS view: Toe from crown.

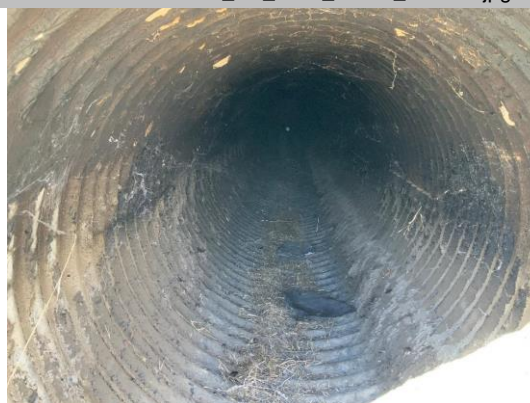
Photo 3 of 3 : UCIP_SP_2022_71041_104155.jpg

LS view: Inside pipe inlet at toe.

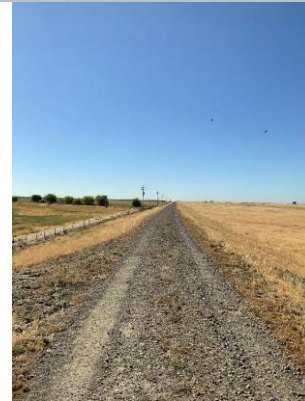
Photo 1 of 3 : UCIP_SP_2022_71042_104163.jpg

Comment Code						
Inspector Comment						
FS_ID:71042 DS_ID:19781 EP_NO: N/A Repair Type: Non-Urgent Crossing Status: Found UCIP Comments: 06/23/2021 The record has been upgraded from No Action Needed to Non-Urgent. DWR DMP internal inspection has not found pipe integrity issues. LOF of crossing is less or equal to 4.0. Recommend next video inspection in 5 years. No permit was found authorizing this encroachment. CVFPB will need to review crossing to determine owner. The UCIP inspection was completed with GEI staff, P. Espinoza. (H. Dunn ? GEI) FIELD_STRUCT_DESC: 36-inch corrugated metal gravity drainage pipe (CMP) through the levee, 9.9 feet below the crown. Flap gate on the waterside (WS) end. Concrete headwall on the landside (LS) end. Concrete U-shaped headwall on the WS end. [Additional Reference(s): DWR Levee Log, 2002, (HLM 20.04). USACE San Joaquin O&M Manual, Unit No. 601, Part No. 1, 1967, Amended in 1978, Revised 20 June 1985, (HLM 20.05). DWR As-Built Specification No. 64-01, Sheet No. 4, 6 November 1963, (HLM 20.05)]. FS Date: 6/23/2021

Levee crown.

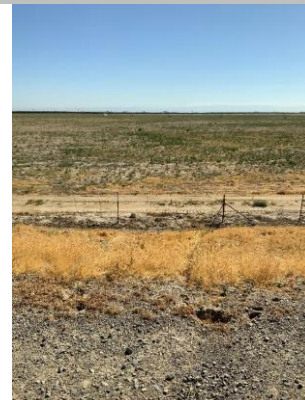
Photo 2 of 3 : UCIP_SP_2022_71042_104164.jpg

LS view: Toe from crown.

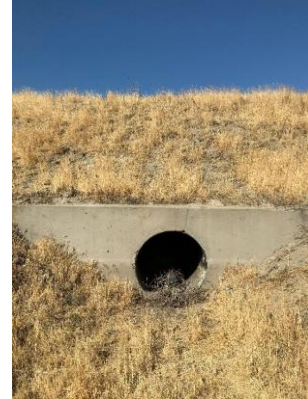
Photo 3 of 3 : UCIP_SP_2022_71042_104161.jpg

LS view: Slope and headwall from toe.

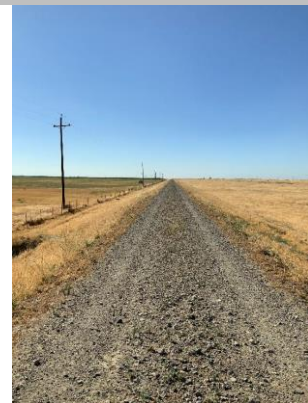
Photo 1 of 3 : UCIP_SP_2022_71043_104170.jpg

FS_ID:71043
DS_ID:19783
EP_NO: N/A
Repair Type: Non-Urgent
Crossing Status: Found
UCIP Comments: 06/23/2021 The record has been upgraded from No Action Needed to Non-Urgent. DWR DMP internal inspection has not found pipe integrity issues. LOF of crossing is less or equal to 4.0. Recommend next video inspection in 5 years. Limited inspection of LS pipe inlet due to tumbleweeds, recommend removal. No permit was found authorizing this encroachment. CVFPB will need to review crossing to determine owner. The UCIP inspection was completed with GEI staff, P. Espinoza. (H. Dunn ? GEI)
FIELD_STRUCT_DESC: 36-inch corrugated metal gravity drainage pipe (CMP) through the levee, 10.6 feet below the crown. Flap gate on the waterside (WS) end. Concrete headwall on each end. [Additional Reference(s): DWR Levee Log, 2002, (HLM 20.18). USACE San Joaquin O&M Manual, Unit No. 601, Part No. 1, 1967, Amended in 1978, Revised 20 June 1985, (HLM 20.18). DWR As-Built Specification No. 64-01, Sheet No. 4, 6 November 1963, (HLM 20.18)].

Levee crown.

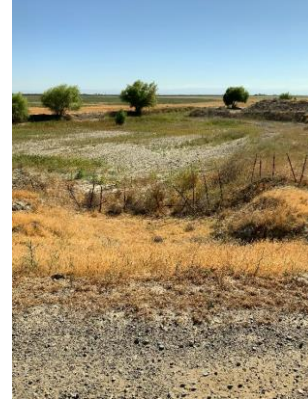
Photo 2 of 3 : UCIP_SP_2022_71043_104171.jpg

LS view: Toe from crown.

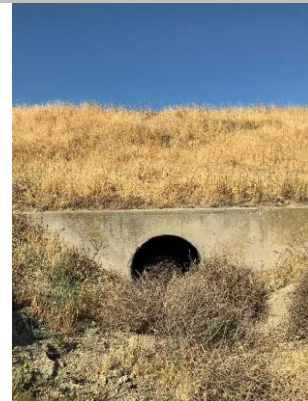
Photo 3 of 3 : UCIP_SP_2022_71043_104168.jpg

LS view: Slope and headwall from toe.

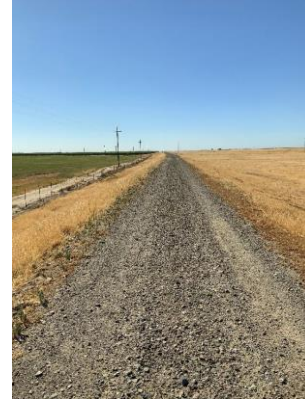
Photo 1 of 3 : UCIP_SP_2022_71044_104176.jpg

Comment Code						
Inspector Comment						
FS_ID:71044 DS_ID:19784 EP_NO: N/A Repair Type: Urgent Crossing Status: Found UCIP Comments: 06/23/2021 The record has been upgraded from Non-Urgent to Urgent. DWR DMP internal inspection has found pipe integrity issues. LOF of crossing is is greater than or equal to 5 and less than 6. Crossing will be monitored until funding becomes available to address the issues. Some tumbleweed buildup at LS pipe inlet, recommend removal. No permit was found authorizing this encroachment. CVFPB will need to review crossing to determine owner. The UCIP inspection was completed with GEI staff, P. Espinoza. (H. Dunn ? GEI)04/23/2014 Dense vegetation limits the inspector's visibility to identify signs of pipe failure (leaks) along the landward slope. Recommend removing vegetation along pipe alignment to conduct proper inspection of structure. (W. Wylie - DWR UCIP) FIELD_STRUCT_DESC: 24-inch corrugated metal gravity drainage pipe (CMP) through the levee, 10.5 feet below the crown. Flap gate on the waterside (WS) end. Concrete headwall on the landside (LS) end. Concrete U-shaped headwall on the WS end. [Additional Reference(s): DWR Levee Log, 2002, (HLM 20.58). USACE San Joaquin O&M Manual, Unit No. 601, Part No. 1, 1967, Amended in 1978, Revised 20 June 1985, (HLM 20.59). DWR As-Built Specification No. 64-01, Sheet No. 4, 6 November 1963, (HLM 20.59)]. FS Date: 6/23/2021

Levee crown.

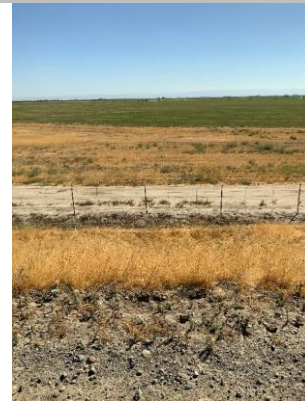
Photo 2 of 3 : UCIP_SP_2022_71044_104178.jpg

LS view: Toe from crown.

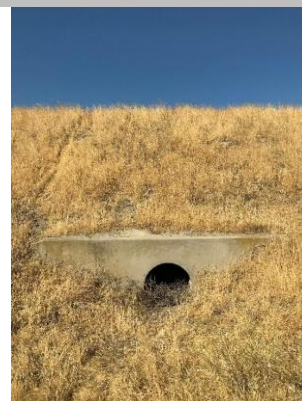
Photo 3 of 3 : UCIP_SP_2022_71044_104179.jpg

LS view: Slope and headwall from toe.

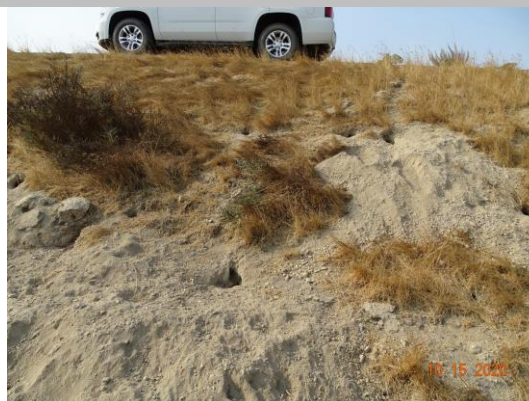
Photo 1 of 1 : SP_2022_NA0010_123_135_20220308_00033.jpg

LM Start	20.93	Rating **	M	Issue No.	135
LM End	20.93	Issue Type +	Ma	Location *	LS
Category	Earthen Levee			GPS Latitude/Longitude	
				Start	End
Item	Animal Control			37.097826 °	37.097826 °
				-120.543984 °	-120.543984 °
DWR ID	DWR_NA0010_05_f_2020_135				
Comment Code					
A3 : No rodents visible, but rodent burrows visible; need to backfill and compact or grout burrows.					
Inspector Comment

View of rodent burrow in the landside slope. (Fall 2020)

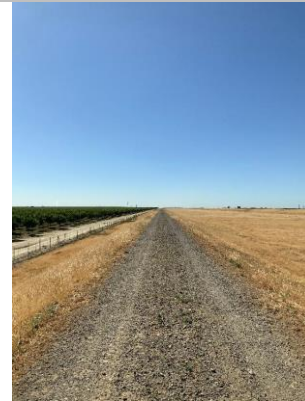
Photo 1 of 3 : UCIP_SP_2022_71045_104183.jpg

FS_ID:71045
DS_ID:19785
EP_NO: N/A
Repair Type: Urgent
Crossing Status: Found
UCIP Comments: 06/23/2021 The record is being upgraded from Non-Urgent to Urgent. DWR DMP internal inspection has found pipe integrity issues. LOF of crossing is is greater than or equal to 5 and less than 6. Crossing will be monitored until funding becomes available to address the issues. Tumbleweed and debris covering LS pipe inlet, recommend removal. No permit was found authorizing this encroachment. CVFPB will need to review crossing to determine owner. The UCIP inspection was completed with GEI staff, P. Espinoza. (H. Dunn ? GEI)04/23/2014 Dense vegetation limits the inspector's visibility to identify signs of pipe failure (leaks) along the landward slope. Recommend removing vegetation along pipe alignment to conduct proper inspection of structure. (W. Wylie - DWR UCIP)
FIELD_STRUCT_DESC: 24-inch corrugated metal gravity drainage pipe (CMP) through the levee, 11.8 feet below the crown. Flap gate on the waterside (WS) end. Concrete headwall on the landside (LS) end. Concrete U-shaped headwall on the WS end. [Additional Reference(s): DWR Levee Log, 2002, (HLM 21.07). USACE San Joaquin O&M Manual, Unit No. 601, Part No. 1, 1967, Amended in 1978, Revised 20 June 1985, (HLM 21.08). DWR As-Built Specification No. 64-01, Sheet No. 5, 6 November 1963, (HLM 21.08)].

Levee crown.

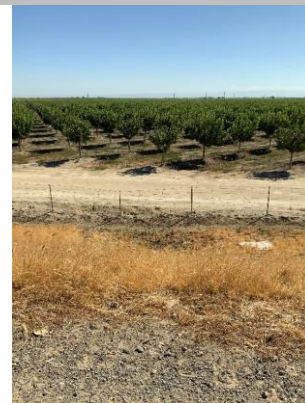
Photo 2 of 3 : UCIP_SP_2022_71045_104185.jpg

LS view: Toe from crown.

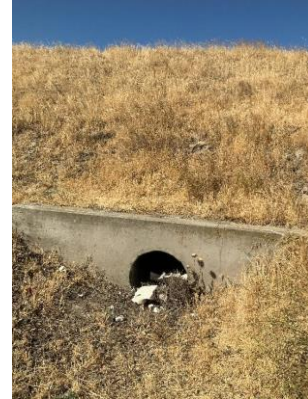
Photo 3 of 3 : UCIP_SP_2022_71045_104181.jpg

LS view: Slope and headwall from toe.

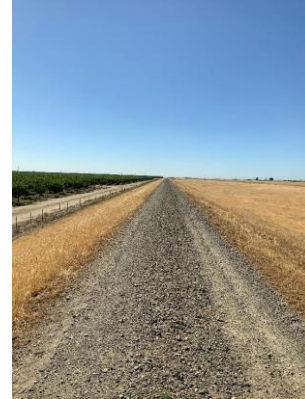
Photo 1 of 3 : UCIP_SP_2022_71046_104192.jpg

Comment Code						
Inspector Comment						
FS_ID:71046 DS_ID:19786 EP_NO: N/A Repair Type: Urgent Crossing Status: Found UCIP Comments: 06/23/2021 The record has been upgraded from Non-Urgent to Urgent. DWR DMP internal inspection has found pipe integrity issues. LOF of crossing is is greater than or equal to 5 and less than 6. Crossing will be monitored until funding becomes available to address the issues. Potential hole in WS flapgate. Sand buildup around WS flapgate preventing it from opening easily, recommend removal. No permit was found authorizing this encroachment. CVFPB will need to review crossing to determine owner. The UCIP inspection was completed with GEI staff, P. Espinoza. (H. Dunn ? GEI)04/23/2014 Dense vegetation limits the inspector's visibility to identify signs of pipe failure (leaks) along the landward slope. Recommend removing vegetation along pipe alignment to conduct proper inspection of structure. (W. Wylie - DWR UCIP) FIELD_STRUCT_DESC: 36-inch corrugated metal gravity drainage pipe (CMP) through the levee, 12.7 feet below the crown. Flap gate on the waterside (WS) end. Concrete headwall on the landside (LS) end. Concrete U-shaped headwall on the WS end. [Additional Reference(s): DWR Levee Log, 2002, (HLM 21.43). USACE San Joaquin O&M Manual, Unit No. 601, Part No. 1, 1967, Amended in 1978, Revised 20 June 1985, (HLM 21.42). DWR As-Built Specification No. 64-01, Sheet No. 5, 6 November 1963, (HLM 21.42)]. FS Date: 6/23/2021

Levee crown.

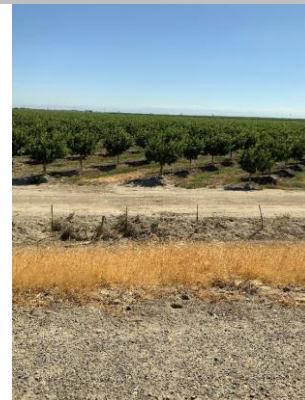
Photo 2 of 3 : UCIP_SP_2022_71046_104193.jpg

LS view: Toe from crown.

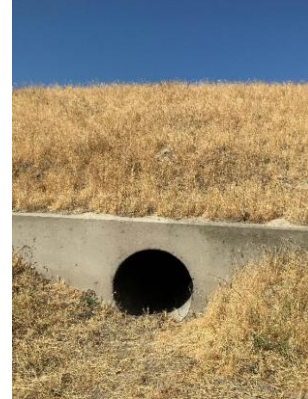
Photo 3 of 3 : UCIP_SP_2022_71046_104190.jpg

LS view: Slope and headwall at toe.

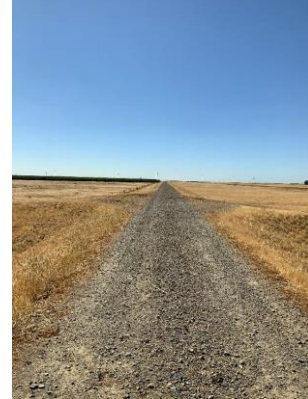
Photo 1 of 3 : UCIP_SP_2022_71047_104198.jpg

Comment Code						
Inspector Comment						
FS_ID:71047 DS_ID:19787 EP_NO: N/A Repair Type: Urgent Crossing Status: Found UCIP Comments: 06/23/2021 The record has been upgraded from Non-Urgent to Urgent. DWR DMP internal inspection has found pipe integrity issues. LOF of crossing is is greater than or equal to 5 and less than 6. Crossing will be monitored until funding becomes available to address the issues. Standing water on both WS outlet and LS inlet, limiting closeup inspection on both sides. Water appeared to be leaking through the WS flapgate, even though it was closed. No permit was found authorizing this encroachment. CVFPB will need to review crossing to determine owner. The UCIP inspection was completed with GEI staff, P. Espinoza. (H. Dunn ? GEI)04/23/2014 Dense vegetation limits the inspector's visibility to identify signs of pipe failure (leaks) along the landward slope. Recommend removing vegetation along pipe alignment to conduct proper inspection of structure. (W. Wylie - DWR UCIP) FIELD_STRUCT_DESC: 24-inch corrugated metal gravity drainage pipe (CMP) through the levee, 12.4 feet below the crown. Flap gate on the waterside (WS) end. Concrete headwall on the landside (LS) end. Concrete U-shaped headwall on the WS end. [Additional Reference(s): DWR Levee Log, 2002, (HLM 21.81). USACE San Joaquin O&M Manual, Unit No. 601, Part No. 1, 1967, Amended in 1978, Revised 20 June 1985, (HLM 21.81). DWR As-Built Specification No. 64-01, Sheet No. 5, 6 November 1963, (HLM 21.81)]. FS Date: 6/23/2021

Levee crown.

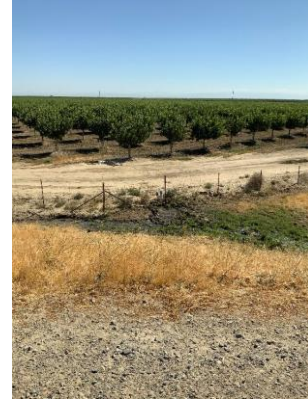
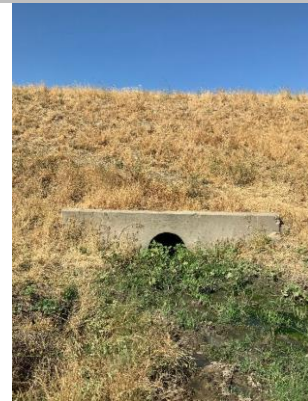
Photo 2 of 3 : UCIP_SP_2022_71047_104199.jpg

LS view: Toe from crown.

LS view: Slope and headwall from toe.

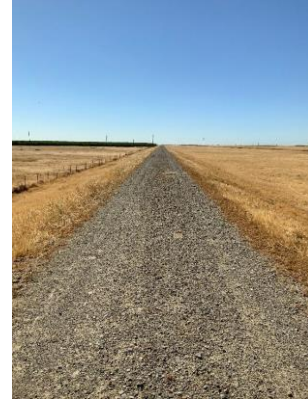
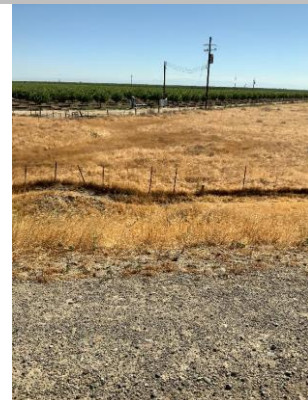
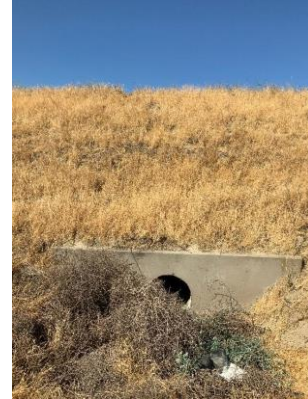
Photo 1 of 3 : UCIP_SP_2022_71048_104205.jpg

Comment Code						
Inspector Comment						
FS_ID:71048 DS_ID:19788 EP_NO: N/A Repair Type: Urgent Crossing Status: Found UCIP Comments: 06/23/2021 The record has been upgraded from Non-Urgent to Urgent. DWR DMP internal inspection has found pipe integrity issues. LOF of crossing is is greater than or equal to 5 and less than 6. Crossing will be monitored until funding becomes available to address the issues. Limited inspection of the LS pipe inlet due to dense tumbleweeds and vegetation, recommend removal. No permit was found authorizing this encroachment. CVFPB will need to review crossing to determine owner. The UCIP inspection was completed with GEI staff, P. Espinoza. (H. Dunn ? GEI)04/23/2014 Dense vegetation limits the inspector's visibility to identify signs of pipe failure (leaks) along the landward slope. Recommend removing vegetation along pipe alignment to conduct proper inspection of structure. (W. Wylie - DWR UCIP) FIELD_STRUCT_DESC: 24-inch corrugated metal gravity drainage pipe (CMP) through the levee, 10.7 feet below the crown. Flap gate on the waterside (WS) end. Concrete headwall on the landside (LS) end. Concrete U-shaped headwall on the WS end. [Additional Reference(s): DWR Levee Log, 2002, (HLM 21.85). USACE San Joaquin O&M Manual, Unit No. 601, Part No. 1, 1967, Amended in 1978, Revised 20 June 1985, (HLM 21.85). DWR As-Built Specification No. 64-01, Sheet No. 5, 6 November 1963, (HLM 21.85)]. FS Date: 6/23/2021

Levee crown.

LS view: Toe from crown.

LS view: Slope and headwall from toe.

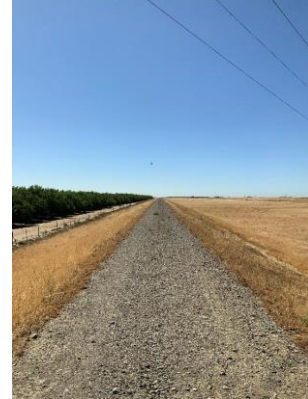
Photo 1 of 3 : UCIP_SP_2022_71049_104212.jpg

Comment Code						
Inspector Comment						
FS_ID:71049 DS_ID:19789 EP_NO: N/A Repair Type: Urgent Crossing Status: Found UCIP Comments: 06/23/2021 The record has been upgraded from Non-Urgent to Urgent. DWR DMP internal inspection has found pipe integrity issues. LOF of crossing is is greater than or equal to 5 and less than 6. Crossing will be monitored until funding becomes available to address the issues. Some vegetation growing over LS pipe inlet, recommend removal. No permit was found authorizing this encroachment. CVFPB will need to review crossing to determine owner. The UCIP inspection was completed with GEI staff, P. Espinoza. (H. Dunn ? GEI)04/23/2014 Dense vegetation limits the inspector's visibility to identify signs of pipe failure (leaks) along the landward slope. Recommend removing vegetation along pipe alignment to conduct proper inspection of structure. Sediment buildup in pipe visible from landward side--recommend contacting owner to clear pipe. (W. Wylie - DWR UCIP) FIELD_STRUCT_DESC: 24-inch corrugated metal gravity drainage pipe (CMP) through the levee, 10.2 feet below the crown. Flap gate on the waterside (WS) end. Concrete headwall on the landside (LS) end. Concrete U-shaped headwall on the WS end. [Additional Reference(s): DWR Levee Log, 2002, (HLM 22.18). USACE San Joaquin O&M Manual, Unit No. 601, Part No. 1, 1967, Amended in 1978, Revised 20 June 1985, (HLM 22.19). DWR As-Built Specification No. 64-01, Sheet No. 5, 6 November 1963, (HLM 22.19)]. FS Date: 6/23/2021

Levee crown.

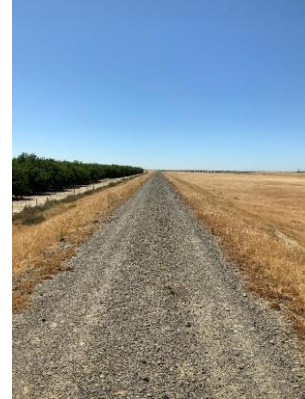
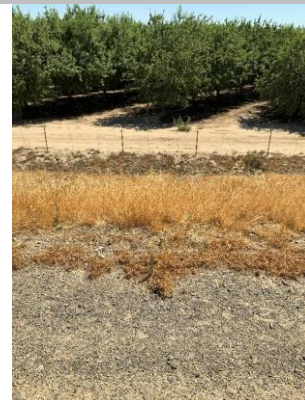
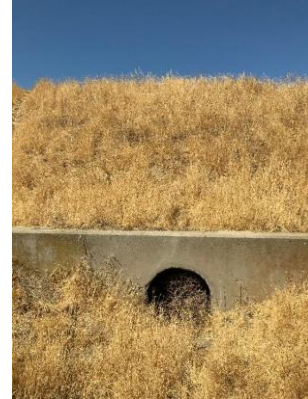
Photo 1 of 3 : UCIP_SP_2022_71050_104219.jpg

Comment Code						
Inspector Comment						
FS_ID:71050 DS_ID:19790 EP_NO: N/A Repair Type: Urgent Crossing Status: Found UCIP Comments: 06/23/2021 The record has been upgraded from Non-Urgent to Urgent. DWR DMP internal inspection has found pipe integrity issues. LOF of crossing is greater than or equal to 5 and less than 6. Crossing will be monitored until funding becomes available to address the issues. Possible hole in WS flapgate. No permit was found authorizing this encroachment. CVFPB will need to review crossing to determine owner. The UCIP inspection was completed with GEI staff, P. Espinoza. (H. Dunn ? GEI)04/23/2014 Dense vegetation limits the inspector's visibility to identify signs of pipe failure (leaks) along the landward slope. Recommend removing vegetation along pipe alignment to conduct proper inspection of structure. Sediment buildup in pipe visible from landward side--recommend contacting owner to clear pipe. (W. Wylie - DWR UCIP) FIELD_STRUCT_DESC: 24-inch corrugated metal gravity drainage pipe (CMP) through the levee, 10.4 feet below the crown. Flap gate on the waterside (WS) end. Concrete headwall on the landside (LS) end. Concrete U-shaped headwall on the WS end. [Additional Reference(s): DWR Levee Log, 2002, (HLM 22.46). USACE San Joaquin O&M Manual, Unit No. 601, Part No. 1, 1967, Amended in 1978, Revised 20 June 1985, (HLM 22.46). DWR As-Built Specification No. 64-01, Sheet No. 6, 6 November 1963, (HLM 22.46)]. FS Date: 6/23/2021

Levee crown.

LS view: Toe from crown.

LS view: Slope and headwall at toe.
