**Flood Control Project Maintenance
Levee Inspections**

Maintenance Issue Types Only, Levee Inspection Report By Mile - Spring 2022

Lower San Joaquin Levee District

Waterway	Bank	Unit Miles	Inspection Start/End	Inspector
Unit No. 01 San Joaquin River	Right	22.52	04/05/2022 04/05/2022	Corey Fujitani

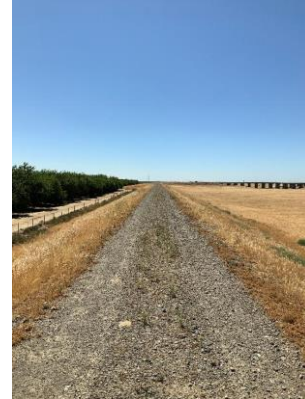
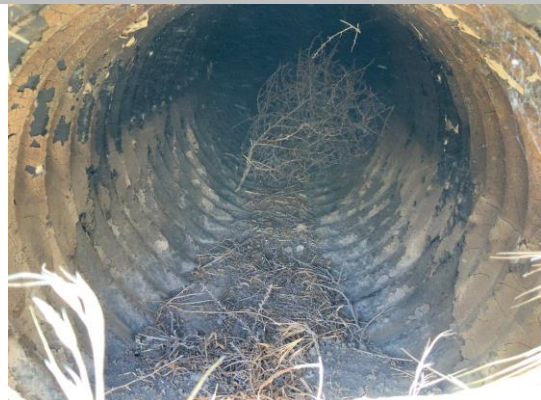
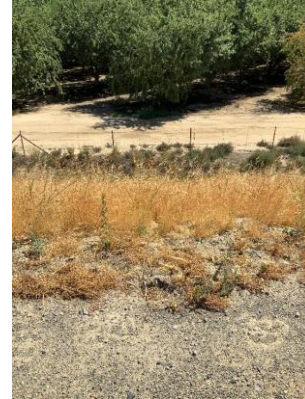
Photo 1 of 3 : UCIP_SP_2022_71051_104227.jpg

Comment Code						
Inspector Comment						
FS_ID:71051 DS_ID:19791 EP_NO: N/A Repair Type: Urgent Crossing Status: Found UCIP Comments: 06/23/2021 The record has been upgraded from Non-Urgent to Urgent. DWR DMP internal inspection has found pipe integrity issues. LOF of crossing is greater than or equal to 5 and less than 6. Crossing will be monitored until funding becomes available to address the issues. Deterioration of the underside of the WS flapgate. No permit was found authorizing this encroachment. CVFPB will need to review crossing to determine owner. The UCIP inspection was completed with GEI staff, P. Espinoza. (H. Dunn ? GEI)04/23/2014 Dense vegetation limits the inspector's visibility to identify signs of pipe failure (leaks) along the landward slope. Recommend removing vegetation along pipe alignment to conduct proper inspection of structure. Sediment buildup in pipe visible from landward side--recommend contacting owner to clear pipe. (W. Wylie - DWR UCIP) FIELD_STRUCT_DESC: 24-inch corrugated metal gravity drainage pipe (CMP) through the levee, 12.2 feet below the crown. Flap gate on the waterside (WS) end. Concrete headwall on the landside (LS) end. Concrete U-shaped headwall on the WS end. [Additional Reference(s): DWR Levee Log, 2002, (HLM 22.79). USACE San Joaquin O&M Manual, Unit No. 601, Part No. 1, 1967, Amended in 1978, Revised 20 June 1985, (HLM 22.79). DWR As-Built Specification No. 64-01, Sheet No. 6, 6 November 1963, (HLM 22.79)]. FS Date: 6/23/2021

Levee crown.

LS view: Inside pipe inlet at toe.

LS view: Toe from crown.

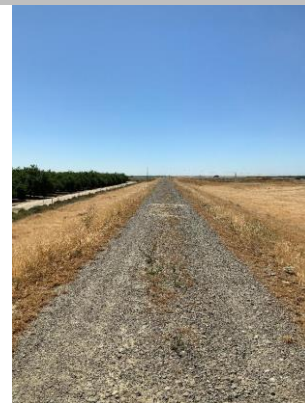
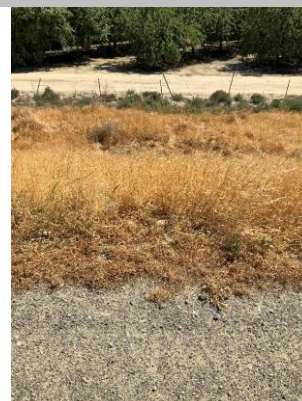
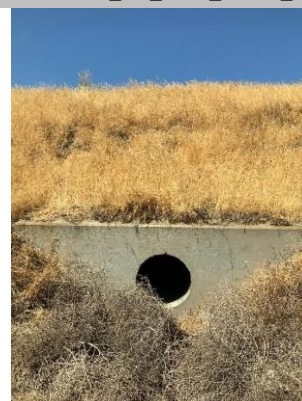
Photo 1 of 3 : UCIP_SP_2022_71052_104235.jpg

Levee crown.

Comment Code					
Inspector Comment					
<p>FS_ID:71052 DS_ID:19792 EP_NO: N/A Repair Type: Urgent Crossing Status: Found UCIP Comments: 06/23/2021 The record has been upgraded from Non-Urgent to Urgent. DWR DMP internal inspection has found pipe integrity issues. LOF of crossing is greater than or equal to 5 and less than 6. Crossing will be monitored until funding becomes available to address the issues. Deterioration of the underside of the WS flapgate. No permit was found authorizing this encroachment. CVFPB will need to review crossing to determine owner. The UCIP inspection was completed with GEI staff, P. Espinoza. (H. Dunn ? GEI)04/23/2014 Dense vegetation limits the inspector's visibility to identify signs of pipe failure (leaks) along the landward slope. Recommend removing vegetation along pipe alignment to conduct proper inspection of structure. (W. Wylie - DWR UCIP) FIELD_STRUCT_DESC: 24-inch corrugated metal gravity drainage pipe (CMP) through the levee, 11.1 feet below the crown. Flap gate on the waterside (WS) end. Concrete headwall on the landside (LS) end. Concrete U-shaped headwall on the WS end. [Additional Reference(s): DWR Levee Log, 2002, (HLM 22.93). USACE San Joaquin O&M Manual, Unit No. 601, Part No. 1, 1967, Amended in 1978, Revised 20 June 1985, (HLM 22.94). DWR As-Built Specification No. 64-01, Sheet No. 6, 6 November 1963, (HLM 22.94)]. FS Date: 6/23/2021</p>

LS view: Toe from crown.

LS view: Headwall and slope from toe.

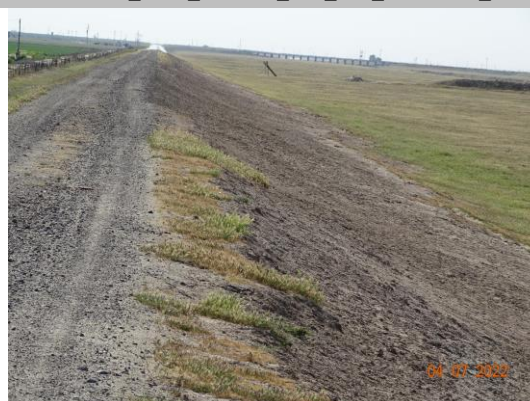
Photo 1 of 1 : SP_2022_NA0010_123_160_20220414_00376.jpg

LM Start	23.24	Rating **	M	Issue No.	160
LM End	23.68	Issue Type +	Ma	Location *	WS
Category	Earthen Levee			GPS Latitude/Longitude	
				Start	End
Item	Erosion / Livestock			37.073064 °	37.068260 °
				-120.516771 °	-120.511583 °
DWR ID	DWR_NA0010_05_f_2018_160				
Comment Code					
E4 : Repair the levee slope damaged by livestock and prevent large animal access.					
Inspector Comment					
There is slope damage caused by livestock on waterside.

Slope damage cause by livestock foot traffic. (Spring 2022)

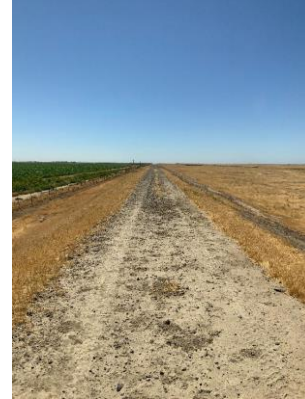
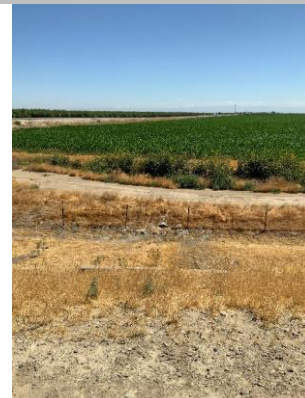
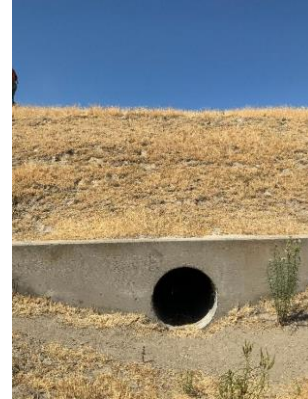
Photo 1 of 3 : UCIP_SP_2022_71054_104342.jpg

Comment Code						
Inspector Comment						
FS_ID:71054 DS_ID:19794 EP_NO: N/A Repair Type: Non-Urgent Crossing Status: Found UCIP Comments: 06/23/2021 The record has been upgraded from No Action Needed to Non-Urgent. DWR DMP internal inspection has not found pipe integrity issues. LOF of crossing is less or equal to 4.0. Recommend next video inspection in 5 years. No permit was found authorizing this encroachment. CVFPB will need to review crossing to determine owner. The UCIP inspection was completed with GEI staff, P. Espinoza. (H. Dunn ? GEI) FIELD_STRUCT_DESC: 30-inch corrugated metal gravity drainage pipe (CMP) through the levee, 11.6 feet below the crown. Flap gate on the waterside (WS) end. Concrete headwall on the landside (LS) end. Concrete U-shaped headwall on the WS end. [Additional Reference(s): DWR Levee Log, 2002, (HLM 23.14). USACE San Joaquin O&M Manual, Unit No. 601, Part No. 1, 1967, Amended in 1978, Revised 20 June 1985, (HLM 23.15). DWR As-Built Specification No. 64-01, Sheet No. 6, 6 November 1963, (HLM 23.15)]. FS Date: 6/23/2021

Levee crown.

LS view: Toe from crown.

LS view: Slope and headwall from toe.

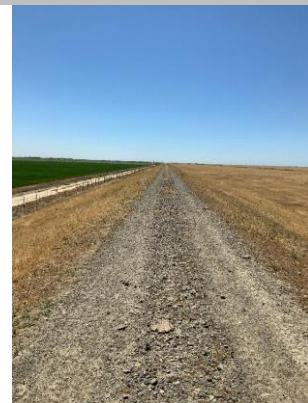
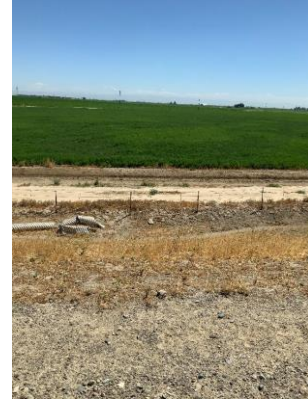
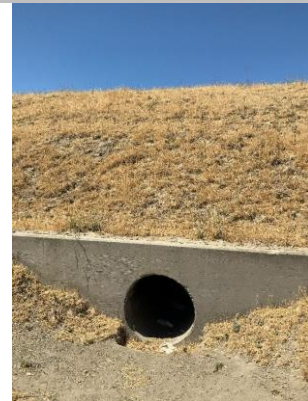
Photo 1 of 3 : UCIP_SP_2022_71057_104379.jpg

FS_ID:71057
 DS_ID:19796
 EP_NO: N/A
 Repair Type: Urgent
 Crossing Status: Found
 UCIP Comments: 06/23/2021 The record has been upgraded from Non-Urgent to Urgent. DWR DMP internal inspection has found pipe integrity issues. LOF of crossing is greater than or equal to 5 and less than 6. Crossing will be monitored until funding becomes available to address the issues. No permit was found authorizing this encroachment. CVFPB will need to review crossing to determine owner. The UCIP inspection was completed with GEI staff, P. Espinoza. (H. Dunn ? GEI)03/25/2014 Sediment buildup in pipe visible from landward side-- recommend contacting owner to clear pipe. (W. Wylie - DWR UCIP) FIELD_STRUCT_DESC: 30-inch corrugated metal gravity drainage pipe (CMP) through the levee, 12.1 feet below the crown. Flap gate on the waterside (WS) end. Concrete U-shaped headwall on the WS end. [Additional Reference(s): DWR Levee Log, 2002, (HLM 23.61). USACE San Joaquin O&M Manual, Unit No. 601, Part No. 1, 1967, Amended in 1978, Revised 20 June 1985, (HLM 23.62). DWR As-Built Specification No. 64-01, Sheet No. 7, 6 November 1963, (HLM 23.62)].

Levee crown.

LS view: Toe from crown.

LS view: Slope and headwall from toe.

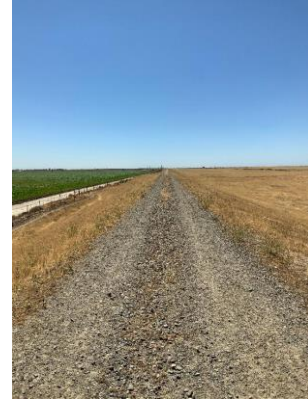
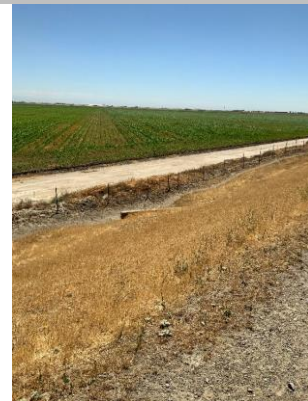
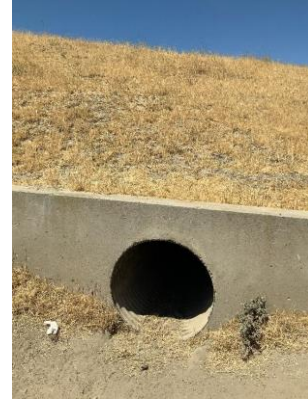
Photo 1 of 3 : UCIP_SP_2022_71058_104386.jpg

Comment Code					
Inspector Comment					
FS_ID:71058 DS_ID:19797 EP_NO: N/A Repair Type: Urgent Crossing Status: Found UCIP Comments: 06/23/2021 The record has been upgraded from Non-Urgent to Urgent. DWR DMP internal inspection has found pipe integrity issues. LOF of crossing is greater than or equal to 5 and less than 6. Crossing will be monitored until funding becomes available to address the issues. Small hole seen in the front of the WS flapgate. No permit was found authorizing this encroachment. CVFPB will need to review crossing to determine owner. The UCIP inspection was completed with GEI staff, P. Espinoza. (H. Dunn ? GEI)03/25/2014 Minor sediment/debris buildup in pipe visible from landward side--recommend contacting owner to clear pipe. (W. Wylie - DWR UCIP) FIELD_STRUCT_DESC: 36-inch corrugated metal gravity drainage pipe (CMP) through the levee, 12.1 feet below the crown. Flap gate on the waterside (WS) end. Concrete headwall on the landside (LS) end. Concrete U-shaped headwall on the WS end. [Additional Reference(s): DWR Levee Log, 2002, (HLM 23.92). USACE San Joaquin O&M Manual, Unit No. 601, Part No. 1, 1967, Amended in 1978, Revised 20 June 1985, (HLM 23.85). DWR As-Built Specification No. 64-01, Sheet No. 7, 6 November 1963, (HLM 23.85)]. FS Date: 6/23/2021

Levee crown.

LS view: Toe from crown.

LS view: Slope and headwall from toe.

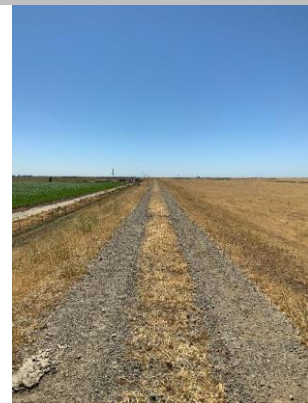
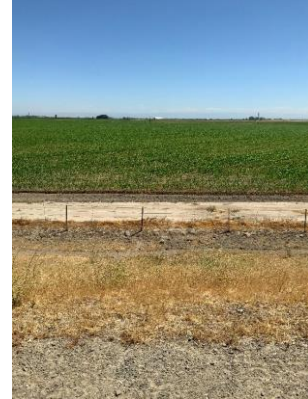
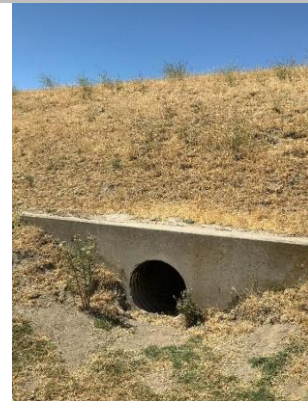
Photo 1 of 3 : UCIP_SP_2022_71059_104393.jpg

FS_ID:71059
DS_ID:19798
EP_NO: N/A
Repair Type: Non-Urgent
Crossing Status: Found
UCIP Comments: 06/23/2021 The record remains Non-Urgent. DWR DMP internal inspection has not found pipe integrity issues. LOF of crossing is less or equal to 4.0. Recommend next video inspection in 5 years. No permit was found authorizing this encroachment. CVFPB will need to review crossing to determine owner. The UCIP inspection was completed with GEI staff, P. Espinoza. (H. Dunn ? GEI) 03/25/2014 Dense vegetation limits the inspector's visibility to identify signs of pipe failure (leaks) along the landward slope. Recommend removing vegetation along pipe alignment to conduct proper inspection of structure. (W. Wylie - DWR UCIP)
FIELD_STRUCT_DESC: 24-inch corrugated metal gravity drainage pipe (CMP) through the levee, 11.2 feet below the crown. Flap gate on the waterside (WS) end. Concrete headwall on the landside (LS) end. Concrete U-shaped headwall on the WS end. [Additional Reference(s): DWR Levee Log, 2002, (HLM 24.18). USACE San Joaquin O&M Manual, Unit No. 601, Part No. 1, 1967, Amended in 1978, Revised 20 June 1985, (HLM 24.18). DWR As-Built Specification No. 64-01, Sheet No. 7, 6 November 1963, (HLM 24.18)].

Levee crown.

LS view: Toe from crown.

LS view: Slope and headwall from toe.

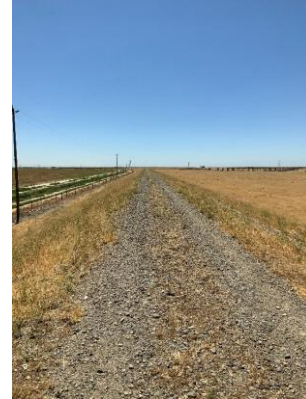
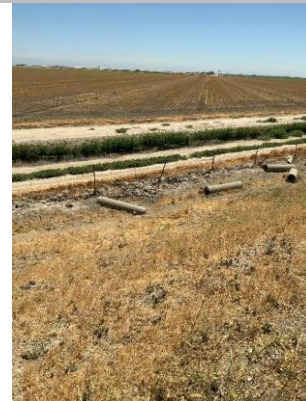
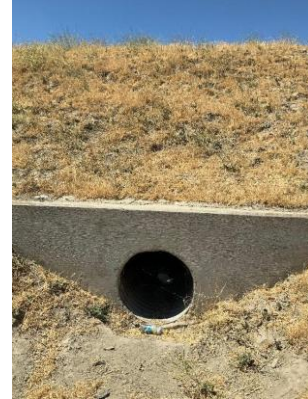
Photo 1 of 3 : UCIP_SP_2022_71060_104402.jpg

FS_ID:71060
DS_ID:19799
EP_NO: N/A
Repair Type: Urgent
Crossing Status: Found
UCIP Comments: 06/23/2021 The record has been upgraded from Non-Urgent to Urgent. DWR DMP internal inspection has found pipe integrity issues. LOF of crossing is greater than or equal to 5 and less than 6. Crossing will be monitored until funding becomes available to address the issues. Hole visible on underneath of flapgate on WS. No permit was found authorizing this encroachment. CVFPB will need to review crossing to determine owner. The UCIP inspection was completed with GEI staff, P. Espinoza. (H. Dunn ? GEI)03/25/2014 Dense vegetation limits the inspector's visibility to identify signs of pipe failure (leaks) along the landward slope. Recommend removing vegetation along pipe alignment to conduct proper inspection of structure. (W. Wylie - DWR UCIP)
FIELD_STRUCT_DESC: 24-inch corrugated metal gravity drainage pipe (CMP) through the levee, 11.2 feet below the crown. Flap gate on the waterside (WS) end. Concrete headwall on the landside (LS) end. Concrete U-shaped headwall on the WS end. [Additional Reference(s): DWR Levee Log, 2002, (HLM 24.46). USACE San Joaquin O&M Manual, Unit No. 601, Part No. 1, 1967, Amended in 1978, Revised 20 June 1985, (HLM 24.46). DWR As-Built Specification No. 64-01, Sheet No. 7, 6 November 1963, (HLM 24.46)].

Levee crown.

LS view: Toe from crown.

LS view: Slope and headwall from toe.

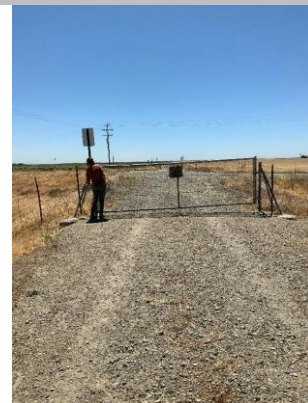
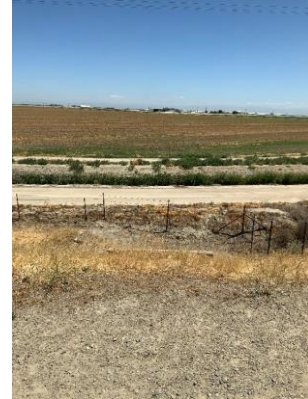
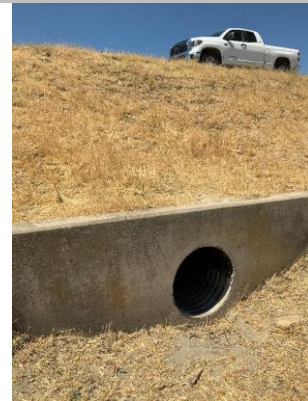
FS_ID:71061
DS_ID:19800
EP_NO: N/A
Repair Type: Non-Urgent
Crossing Status: Found
UCIP Comments: 06/23/2021 The record has been upgraded from No Action Needed to Non-Urgent. DWR DMP internal inspection has not found pipe integrity issues. LOF of crossing is less or equal to 4.0. Recommend next video inspection in 5 years. No permit was found authorizing this encroachment. CVFPB will need to review crossing to determine owner. The UCIP inspection was completed with GEI staff, P. Espinoza. (H. Dunn ? GEI)
FIELD_STRUCT_DESC: 24-inch corrugated metal gravity drainage pipe (CMP) through the levee, 10.7 feet below the crown. Flap gate on the waterside (WS) end. Concrete headwall on the landside (LS) end. Concrete U-shaped headwall on the WS end. [Additional Reference(s): DWR Levee Log, 2002, (HLM 24.82). USACE San Joaquin O&M Manual, Unit No. 601, Part No. 1, 1967, Amended in 1978, Revised 20 June 1985, (HLM 24.82). DWR As-Built Specification No. 64-01, Sheet No. 7, 6 November 1963, (HLM 24.82)].

Levee crown.

LS view: Toe from crown.

LS view: Slope and headwall from toe.

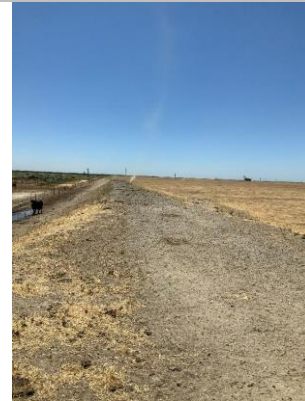
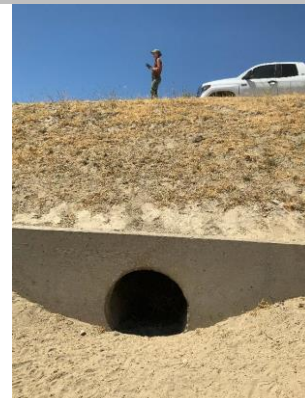
Comment Code						
Inspector Comment						
FS_ID:71062 DS_ID:19801 EP_NO: N/A Repair Type: Non-Urgent Crossing Status: Found UCIP Comments: 06/23/2021 The record has been upgraded from No Action Needed to Non-Urgent. DWR DMP internal inspection has not found pipe integrity issues. LOF of crossing is less or equal to 4.0. Recommend next video inspection in 5 years. No permit was found authorizing this encroachment. CVFPB will need to review crossing to determine owner. The UCIP inspection was completed with GEI staff, P. Espinoza. (H. Dunn ? GEI) FIELD_STRUCT_DESC: 30-inch corrugated metal gravity drainage pipe (CMP) through the levee, 10.9 feet below the crown. Flap gate on the waterside (WS) end. Concrete headwall on the landside (LS) end. Concrete U-shaped headwall on the WS end. [Additional Reference(s): DWR Levee Log, 2002, (HLM 24.86). USACE San Joaquin O&M Manual, Unit No. 601, Part No. 1, 1967, Amended in 1978, Revised 20 June 1985, (HLM 24.87). DWR As-Built Specification No. 64-01, Sheet No. 7, 6 November 1963, (HLM 24.87)]. FS Date: 6/23/2021

Levee crown.

LS view: Slope and headwall from toe.

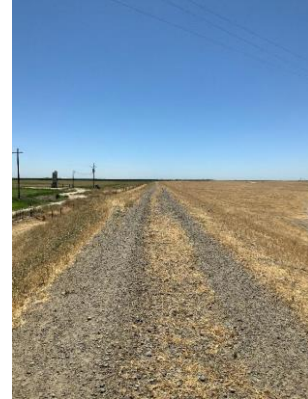
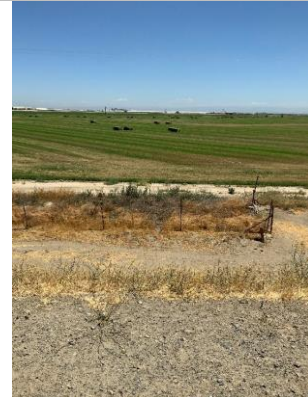
Comment Code						
Inspector Comment						
FS_ID:71064 DS_ID:19803 EP_NO: N/A Repair Type: Non-Urgent Crossing Status: Found UCIP Comments: 06/23/2021 The record remains Non-Urgent. DWR DMP internal inspection has not found pipe integrity issues. LOF of crossing is less or equal to 4.0. Recommend next video inspection in 5 years. No permit was found authorizing this encroachment. CVFPB will need to review crossing to determine owner. The UCIP inspection was completed with GEI staff, P. Espinoza. (H. Dunn ? GEI) 03/25/2014 Flapgate propped open during flood season. (W. Wylie - DWR UCIP) FIELD_STRUCT_DESC: 30-inch corrugated metal gravity drainage pipe (CMP) through the levee, 11.3 feet below the crown. Flap gate on the waterside (WS) end. Concrete headwall on the landside (LS) end. Concrete U-shaped headwall on the WS end. [Additional Reference(s): DWR Levee Log, 2002, (HLM 25.14). USACE San Joaquin O&M Manual, Unit No. 601, Part No. 1, 1967, Amended in 1978, Revised 20 June 1985, (recorded incorrectly as HLM 25.43, should be 25.13). DWR As-Built Specification No. 64-01, Sheet No. 8, 6 November 1963, (HLM 25.13)]. FS Date: 6/23/2021

Levee crown.

LS view: Toe from crown.

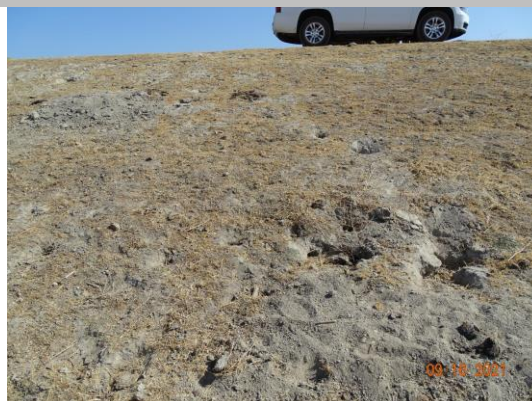
Photo 1 of 1 : SP_2022_NA0010_123_168_20220308_00056.jpg

LM Start	25.46	Rating **	M	Issue No.	168
LM End	25.46	Issue Type +	Ma	Location *	WS
Category	Earthen Levee			GPS Latitude/Longitude	
				Start	End
Item	Animal Control			37.049217 °	37.049217 °
				-120.489881 °	-120.489881 °
DWR ID	DWR_NA0010_05_f_2021_168				
Comment Code					
A3 : No rodents visible, but rodent burrows visible; need to backfill and compact or grout burrows.					
Inspector Comment

View of rodent burrows on the waterside slope. (Fall 2021)

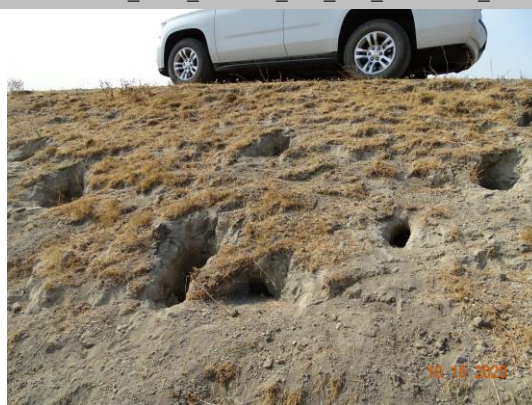
Photo 1 of 1 : SP_2022_NA0010_123_148_20220308_00042.jpg

LM Start	25.58	Rating **	U	Issue No.	148
LM End	25.60	Issue Type +	Ma	Location *	LS
Category	Earthen Levee			GPS Latitude/Longitude	
				Start	End
Item	Animal Control			37.047827 °	37.047551 °
				-120.488738 °	-120.488527 °
DWR ID	DWR_NA0010_05_f_2020_148				
Comment Code					
A3 : No rodents visible, but rodent burrows visible; need to backfill and compact or grout burrows.					
Inspector Comment

View of burrows in the landside. (Fall 2020)

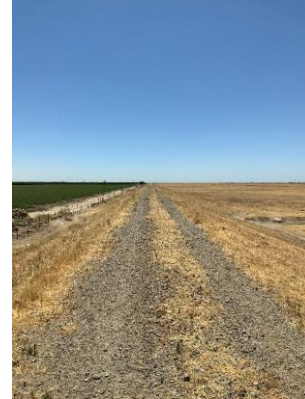
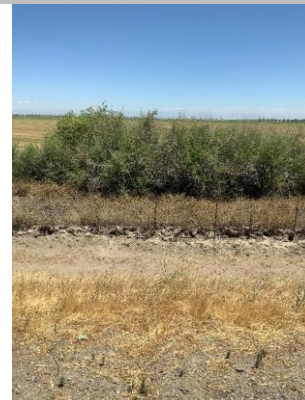
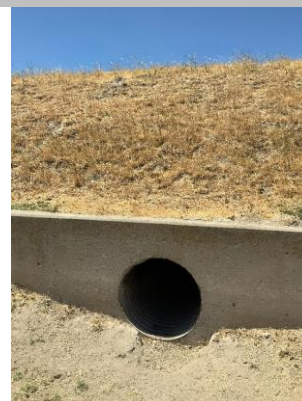
Comment Code						
Inspector Comment						
FS_ID:71065 DS_ID:19804 EP_NO: N/A Repair Type: Urgent Crossing Status: Found UCIP Comments: 06/23/2021 The record has been upgraded from Non-Urgent to Urgent. DWR DMP internal inspection has found pipe integrity issues. LOF of crossing is greater than or equal to 5 and less than 6. Crossing will be monitored until funding becomes available to address the issues. No permit was found authorizing this encroachment. CVFPB will need to review crossing to determine owner. The UCIP inspection was completed with GEI staff, P. Espinoza. (H. Dunn ? GEI)03/25/2014 Dense vegetation limits the inspector's visibility to identify signs of pipe failure (leaks) along the landward slope. Recommend removing vegetation along pipe alignment to conduct proper inspection of structure. Sediment buildup in pipe visible from landward side--recommend contacting owner to clear pipe. (W. Wylie - DWR UCIP) FIELD_STRUCT_DESC: 30-inch corrugated metal gravity drainage pipe (CMP) through the levee, 12.0 feet below the crown. Flap gate on the waterside (WS) end. Concrete headwall on the landside (LS) end. Concrete U-shaped headwall on the WS end. [Additional Reference(s): DWR Levee Log, 2002, (HLM 25.51). USACE San Joaquin O&M Manual, Unit No. 601, Part No. 1, 1967, Amended in 1978, Revised 20 June 1985, (HLM 25.51). DWR As-Built Specification No. 64-01, Sheet No. 8, 6 November 1963, (HLM 25.51)]. FS Date: 6/23/2021

Levee crown.

LS view: Toe from crown.

LS view: Slope and headwall from toe.

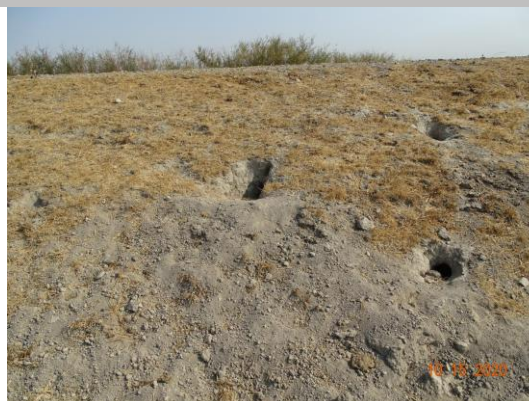
Photo 1 of 1 : SP_2022_NA0010_123_124_20220308_00024.jpg

LM Start	25.61	Rating **	M	Issue No.	124
LM End	25.61	Issue Type +	Ma	Location *	WS
Category	Earthen Levee			GPS Latitude/Longitude	
				Start	End
Item	Animal Control			37.047416 °	37.047416 °
				-120.488411 °	-120.488411 °
DWR ID	DWR_NA0010_05_f_2017_124				
Comment Code					
A1 : Exterminate rodents and backfill and compact or grout burrows.					
Inspector Comment

Looking east at the waterside slope. (Fall 2020)

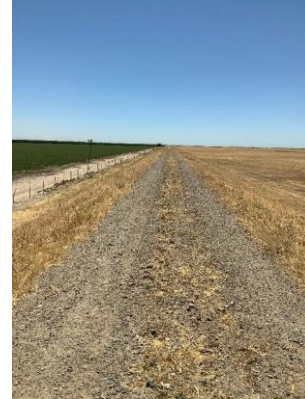
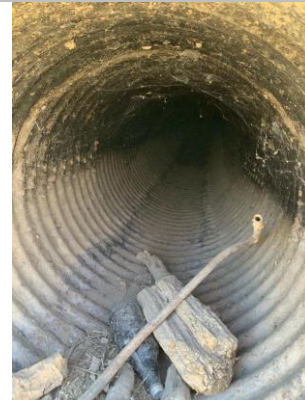
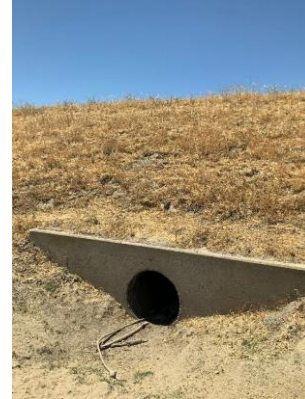
Comment Code					
Inspector Comment					
FS_ID:71066 DS_ID:19805 EP_NO: N/A Repair Type: Urgent Crossing Status: Found UCIP Comments: 06/23/2021 The record has been upgraded from Non-Urgent to Urgent. DWR DMP internal inspection has found pipe integrity issues. LOF of crossing is greater than or equal to 5 and less than 6. Crossing will be monitored until funding becomes available to address the issues. No permit was found authorizing this encroachment. CVFPB will need to review crossing to determine owner. The UCIP inspection was completed with GEI staff, P. Espinoza. (H. Dunn ? GEI)03/25/2014 Sediment buildup in pipe visible from landward side-- recommend contacting owner to clear pipe. (W. Wylie - DWR UCIP) FIELD_STRUCT_DESC: 30-inch corrugated metal gravity drainage pipe (CMP) through the levee, 12.1 feet below the crown. Flap gate on the waterside (WS) end. Concrete headwall on the landside (LS) end. Concrete U-shaped headwall on the WS end. [Additional Reference(s): DWR Levee Log, 2002, (HLM 25.53). USACE San Joaquin O&M Manual, Unit No. 601, Part No. 1, 1967, Amended in 1978, Revised 20 June 1985, (HLM 25.53). DWR As-Built Specification No. 64-01, Sheet No. 8, 6 November 1963, (HLM 25.53)]. FS Date: 6/23/2021

Levee crown.

LS view: Inside pipe inlet at toe.

LS view: Slope and headwall from toe.

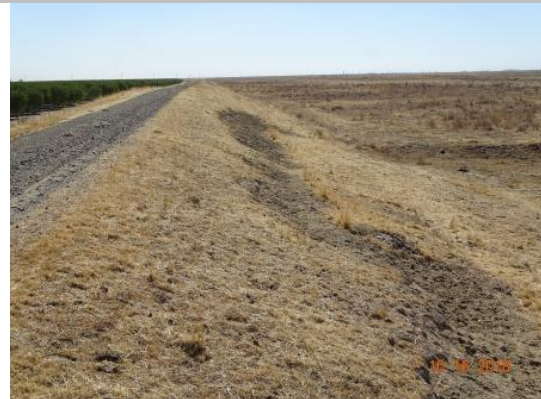
Photo 1 of 1 : SP_2022_NA0010_123_161_20220308_00051.jpg

LM Start	26.17	Rating **	M	Issue No.	161
LM End	26.21	Issue Type +	Ma	Location *	WS
Category	Earthen Levee			GPS Latitude/Longitude	
				Start	End
Item	Erosion / Livestock			37.040434 °	37.040043 °
				-120.483086 °	-120.482795 °
DWR ID	DWR_NA0010_05_f_2018_161				
Comment Code					
E4 : Repair the levee slope damaged by livestock and prevent large animal access.					
Inspector Comment					
Waterside slope damage is caused by livestock foot traffic.

Slope damage on waterside. (Fall 2018)

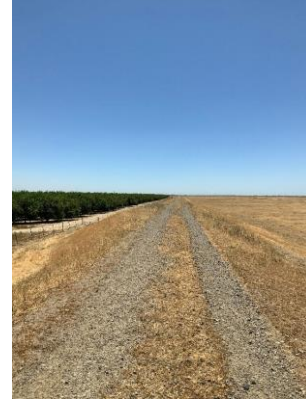
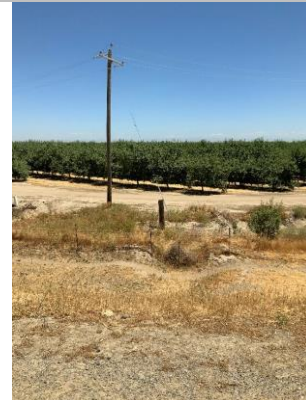
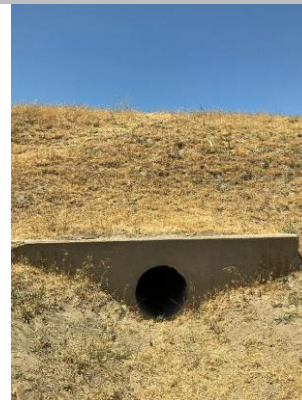
Comment Code						
Inspector Comment						
FS_ID:71067 DS_ID:19806 EP_NO: N/A Repair Type: Urgent Crossing Status: Found UCIP Comments: 06/23/2021 The record has been upgraded from Non-Urgent to Urgent. DWR DMP internal inspection has found pipe integrity issues. LOF of crossing is greater than or equal to 5 and less than 6. Crossing will be monitored until funding becomes available to address the issues. No permit was found authorizing this encroachment. CVFPB will need to review crossing to determine owner. The UCIP inspection was completed with GEI staff, P. Espinoza. (H. Dunn ? GEI)03/25/2014 Sediment buildup in pipe visible from landward side-- recommend contacting owner to clear pipe. (W. Wylie - DWR UCIP) FIELD_STRUCT_DESC: 24-inch corrugated metal gravity drainage pipe (CMP) through the levee, 10.0 feet below the crown. Flap gate on the waterside (WS) end. Concrete headwall on the landside (LS) end. Concrete U-shaped headwall on the WS end. [Additional Reference(s): DWR Levee Log, 2002, (HLM 26.10). USACE San Joaquin O&M Manual, Unit No. 601, Part No. 1, 1967, Amended in 1978, Revised 20 June 1985, (HLM 26.11). DWR As-Built Specification No. 64-01, Sheet No. 8, 6 November 1963, (HLM 26.11)]. FS Date: 6/23/2021

Levee crown.

LS view: Toe from crown.

LS view: Slope and headwall from toe.

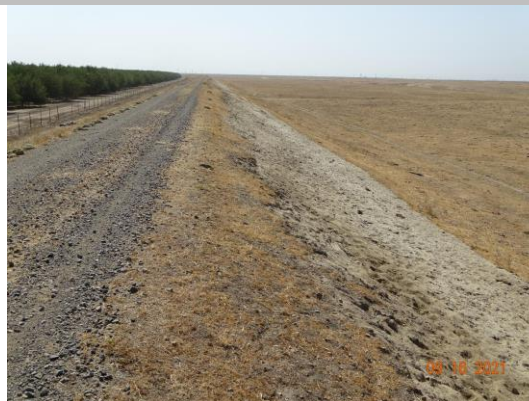
Photo 1 of 1 : SP_2022_NA0010_123_169_20220308_00057.jpg

LM Start	26.30	Rating **	A/W	Issue No.	169
LM End	26.69	Issue Type +	Ma	Location *	WS
Category	Earthen Levee			GPS Latitude/Longitude	
				Start	End
Item	Erosion / Livestock			37.038855 °	37.034140 °
				-120.481877 °	-120.478076 °
DWR ID	DWR_NA0010_05_f_2021_169				
Comment Code					
E4 : Repair the levee slope damaged by livestock and prevent large animal access.					
Inspector Comment					
Damage to the waterside slope from cattle traffic and minor damage on the landside slope.

View of slope damage from cattle traffic. (Fall 2021)

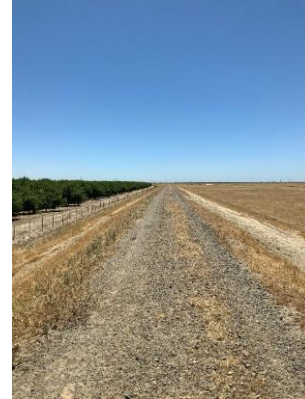
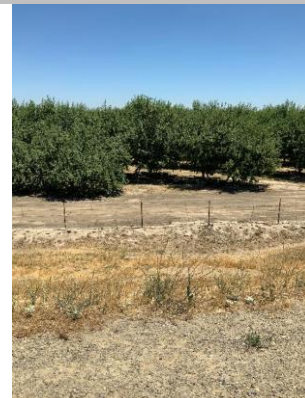
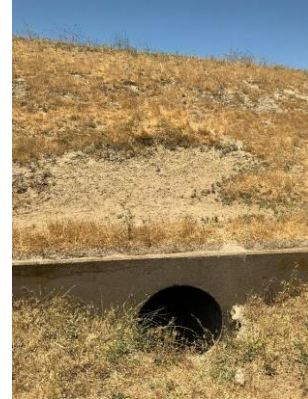
Comment Code					
Inspector Comment					
FS_ID:71068 DS_ID:19807 EP_NO: N/A Repair Type: Urgent Crossing Status: Found UCIP Comments: 06/23/2021 The record has been upgraded from No Action Needed to Urgent. DWR DMP internal inspection has found pipe integrity issues. LOF of crossing is greater than or equal to 5 and less than 6. Crossing will be monitored until funding becomes available to address the issues. No permit was found authorizing this encroachment. CVFPB will need to review crossing to determine owner. The UCIP inspection was completed with GEI staff, P. Espinoza. (H. Dunn ? GEI) FIELD_STRUCT_DESC: 36-inch corrugated metal gravity drainage pipe (CMP) through the levee, 13.0 feet below the crown. Flap gate on the waterside (WS) end. Concrete headwall on the landside (LS) end. Concrete U-shaped headwall on the WS end. [Additional Reference(s): DWR Levee Log, 2002, (HLM 26.29). USACE San Joaquin O&M Manual, Unit No. 601, Part No. 1, 1967, Amended in 1978, Revised 20 June 1985, (HLM 26.29). DWR As-Built Specification No. 64-01, Sheet No. 9, 6 November 1963, (HLM 26.29)]. FS Date: 6/23/2021

Levee crown.

LS view: Toe from crown.

LS view: Slope and headwall from toe.

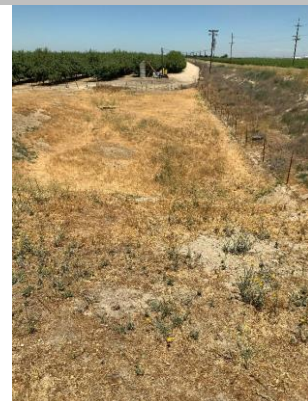
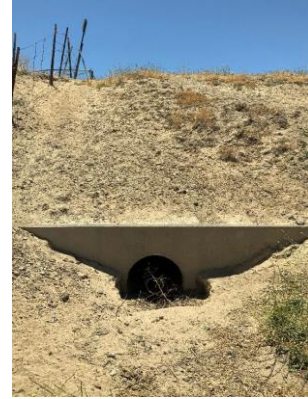
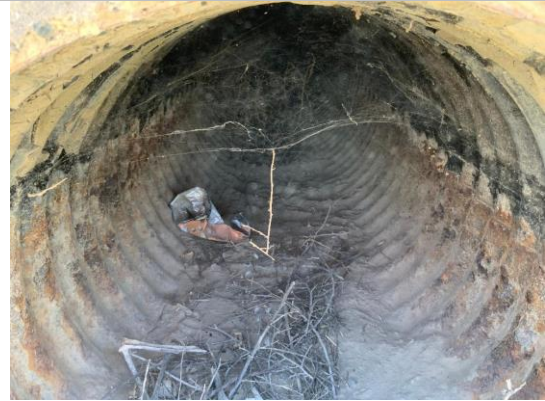
FS_ID:71069
 DS_ID:19808
 EP_NO: N/A
 Repair Type: Urgent
 Crossing Status: Found
 UCIP Comments: 06/23/2021 The record has been upgraded from Non-Urgent to Urgent. LOF of crossing is greater than or equal to 5 and less than 6. Crossing will be monitored until funding becomes available to address issues. No permit was found authorizing this encroachment. CVFPB will need to review crossing to determine owner. The UCIP inspection was completed with GEI staff, P. Espinoza. (H. Dunn ? GEI)03/25/2014 Pipe has heavy silt buildup visible from landward side--recommend contacting owner to clear pipe. (W. Wylie - DWR UCIP)
 FIELD_STRUCT_DESC: 24-inch corrugated metal gravity drainage pipe (CMP) through the levee, 11.4 feet below the crown. Flap gate on the waterside (WS) end. Concrete headwall on the landside (LS) end. Concrete U-shaped headwall on the WS end. [Additional Reference(s): DWR Levee Log, 2002, (HLM 26.85). USACE San Joaquin O&M Manual, Unit No. 601, Part No. 1, 1967, Amended in 1978, Revised 20 June 1985, (HLM 26.85). DWR As-Built Specification No. 64-01, Sheet No. 9, 6 November 1963, (HLM 26.85)].

LS view: Toe from crown.

LS view: Slope and headwall from toe.

LS view: Inside of pipe inlet at toe.

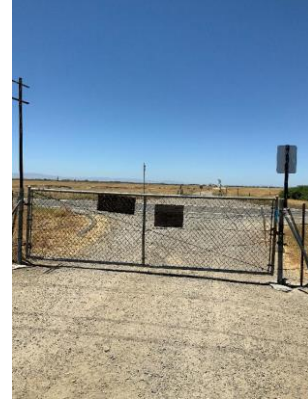
Photo 1 of 3 : UCIP_SP_2022_71071_104358.jpg

Comment Code						
Inspector Comment						
FS_ID:71071 DS_ID:19748 EP_NO: N/A Repair Type: Urgent Crossing Status: Found UCIP Comments: 06/23/2021 Record has been upgraded from Non-Urgent to Urgent. DWR DMP internal inspection has found pipe integrity issues. LOF of crossing is greater than or equal to 5 and less than 6. Crossing will be monitored until funding becomes available to address the issues. Limited inspection of LS inlet due to dirt and tumbleweeds, recommend removal. Unidentified PVC pipe installed at mouth of inlet pipe on LS. No permit was found authorizing this encroachment. CVFPB will need to review crossing to determine owner. The UCIP inspection was completed with GEI staff, H.Dunn. (P.Espinoza ? GEI)03/25/2014 Tumble weed buildup at inlet may create blockage and should be removed. (W. Wylie - DWR UCIP) FIELD_STRUCT_DESC: 24-inch corrugated metal gravity drainage pipe (CMP) through the levee, 11.3 feet below the crown. Flap gate on the waterside (WS) end. Concrete headwall on the landside (LS) end. Concrete U-shaped headwall on the WS end. [Additional Reference(s): DWR Levee Log, 2002, (HLM 26.87). USACE San Joaquin O&M Manual, Unit No. 601, Part No. 1, 1967, Amended in 1978, Revised 20 June 1985, (HLM 26.87). DWR As-Built Specification No. 64-01, Sheet No. 9, 6 November 1963, (HLM 26.87)]. FS Date: 6/23/2021 4:25:00 PM

View from levee crown.

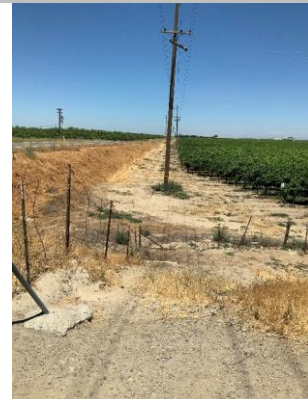
Photo 2 of 3 : UCIP_SP_2022_71071_104359.jpg

LS view from crown.

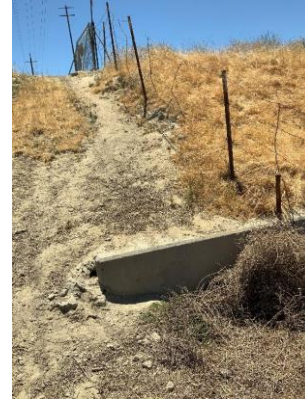
Photo 3 of 3 : UCIP_SP_2022_71071_104361.jpg

LM Start	26.97	Rating **	U	Issue No.	93 (cont)
LM End	26.97	Issue Type +	Ma	Location *	
Category	Supplemental			GPS Latitude/Longitude	
				Start	End
Item	DWR UCIP LMA Responsibility			37.032680 °	37.032680 °
				-120.473454 °	-120.473454 °
DWR ID	19748

LS view from toe: concrete headwall at inlet

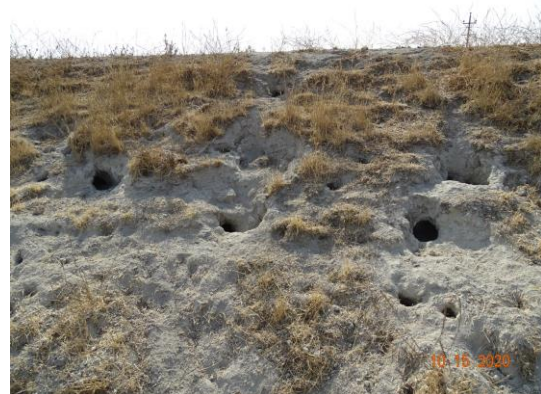
Photo 1 of 1 : SP_2022_NA0010_123_162_20220308_00052.jpg

LM Start	26.99	Rating **	U	Issue No.	162
LM End	27.04	Issue Type +	Ma	Location *	LS
Category	Earthen Levee			GPS Latitude/Longitude	
				Start	End
Item	Animal Control			37.032651 °	37.032659 °
				-120.473205 °	-120.472190 °
DWR ID	DWR_NA0010_05_f_2018_162				
Comment Code					
A1 : Exterminate rodents and backfill and compact or grout burrows.					
Inspector Comment					
Several rodent burrows with large quantities of material displaced noted in this section.

Several rodent burrows noted in this section of the levee. (Fall 2020)

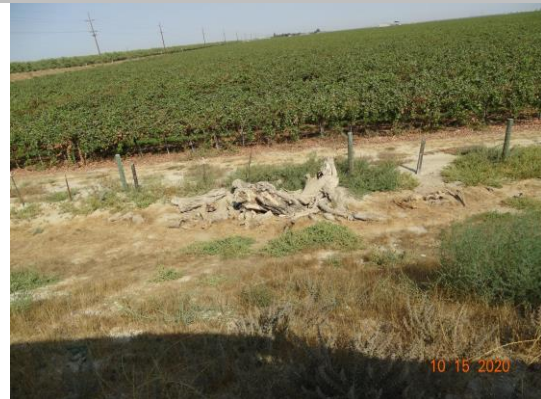
Photo 1 of 1 : SP_2022_NA0010_123_125_20220308_00025.jpg

LM Start	27.01	Rating **	M	Issue No.	125
LM End	27.01	Issue Type +	Ma	Location *	LS
Category	Earthen Levee			GPS Latitude/Longitude	
				Start	End
Item	Encroachments			37.032675 °	37.032675 °
				-120.472841 °	-120.472841 °
DWR ID	DWR_NA0010_05_s_2021_125				
Comment Code					
TR : Tree or limb					
Inspector Comment

Prunings left on the landside toe. (Fall 2020)

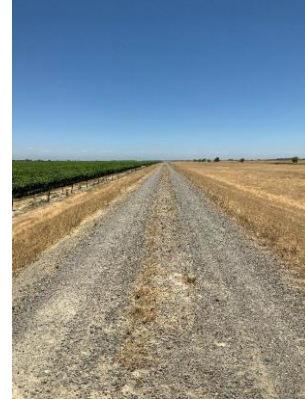
Photo 1 of 3 : UCIP_SP_2022_71072_104352.jpg

Comment Code						
Inspector Comment						
FS_ID:71072						
DS_ID:19749						
EP_NO: N/A						
Repair Type: Urgent						
Crossing Status: Found						
UCIP Comments: 06/23/2021 The record has been upgraded from No Action Needed to Urgent. DWR DMP internal inspection has found pipe integrity issues. LOF of crossing is greater than or equal to 5 and less than 6. Crossing will be monitored until funding becomes available to address the issues. No permit was found authorizing this encroachment. CVFPB will need to review crossing to determine owner. The UCIP inspection was completed with GEI staff, H.Dunn. (P.Espinoza ? GEI)						
FIELD_STRUCT_DESC: 36-inch corrugated metal gravity drainage pipe (CMP) through the levee, 12.0 feet below the crown. Flap gate on the waterside (WS) end. Concrete headwall on the landside (LS) end. Concrete U-shaped headwall on the WS end. [Additional Reference(s): DWR Levee Log, 2002, (HLM 27.21). USACE San Joaquin O&M Manual, Unit No. 601, Part No. 1, 1967, Amended in 1978, Revised 20 June 1985, (HLM 27.22). DWR As-Built Specification No. 64-01, Sheet No. 10, 6 November 1963, (HLM 27.22)].

View from levee crown.

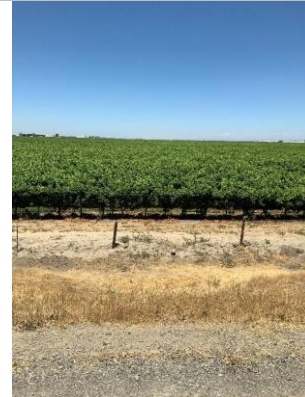
Photo 2 of 3 : UCIP_SP_2022_71072_104354.jpg

LS view from crown.

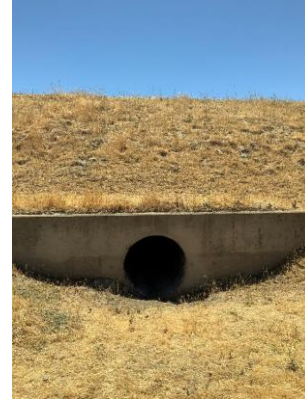
Photo 3 of 3 : UCIP_SP_2022_71072_104356.jpg

LS view from toe: concrete headwall at inlet.

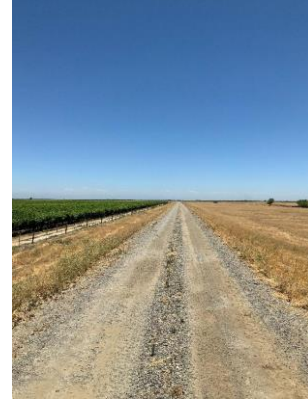
Photo 1 of 3 : UCIP_SP_2022_71073_104347.jpg

Comment Code					
Inspector Comment					
FS_ID:71073 DS_ID:19750 EP_NO: N/A Repair Type: Non-Urgent Crossing Status: Found UCIP Comments: 06/23/2021 The record remains Non-Urgent. DWR DMP internal inspection has not found pipe integrity issues. LOF of crossing is less or equal to 4.0. Recommend next video inspection in 5 years. Sediment buildup in inlet pipe; recommend removal. No permit was found authorizing this encroachment. CVFPB will need to review crossing to determine owner. The UCIP inspection was completed with GEI staff, P. Espinoza. (H. Dunn ? GEI) 03/25/2014 Animal Burrowing activity at LS toe may undermine headwall. (W. Wylie - DWR UCIP) FIELD_STRUCT_DESC: 24-inch corrugated metal gravity drainage pipe (CMP) through the levee, 10.8 feet below the crown. Flap gate on the waterside (WS) end. Concrete headwall on the landside (LS) end. Concrete U-shaped headwall on the WS end. [Additional Reference(s): DWR Levee Log, 2002, (HLM 28.17). USACE San Joaquin O&M Manual, Unit No. 601, Part No. 1, 1967, Amended in 1978, Revised 20 June 1985, (HLM 28.17). DWR As-Built Specification No. 64-01, Sheet No. 10, 6 November 1963, (HLM 28.17)]. FS Date: 6/23/2021

View from levee crown.

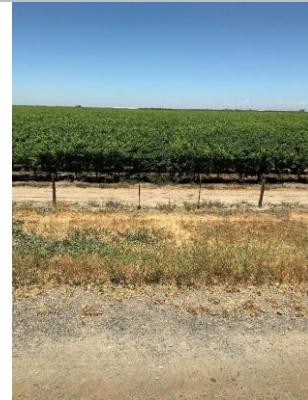
Photo 2 of 3 : UCIP_SP_2022_71073_104346.jpg

LS view from crown.

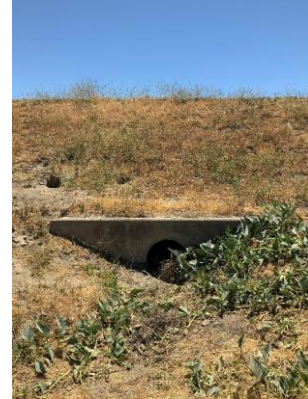
Photo 3 of 3 : UCIP_SP_2022_71073_104350.jpg

LS view from toe: concrete headwall at inlet.

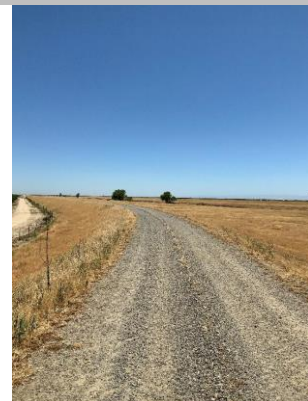
Photo 1 of 3 : UCIP_SP_2022_71074_104318.jpg

FS_ID:71074
DS_ID:19751
EP_NO: N/A
Repair Type: Urgent
Crossing Status: Found
UCIP Comments: 06/23/2021 The record has been upgraded from No Action Needed to Urgent. DWR DMP internal inspection has found pipe integrity issues. LOF of crossing is between 5 and 6. Crossing will be monitored until funding becomes available to address the issues. Sediment build up in LS pipe inlet; recommend removal. No permit was found authorizing this encroachment. CVFPB will need to review crossing to determine owner. The UCIP inspection was completed with GEI staff, H.Dunn. (P.Espinoza ? GEI)
FIELD_STRUCT_DESC: 30-inch corrugated metal gravity drainage pipe (CMP) through the levee, 9.8 feet below the crown. Flap gate on the waterside (WS) end. Concrete headwall on the landside (LS) end. Concrete U-shaped headwall on the WS end. [Additional Reference(s): DWR Levee Log, 2002, (HLM 28.69). USACE San Joaquin O&M Manual, Unit No. 601, Part No. 1, 1967, Amended in 1978, Revised 20 June 1985, (HLM 28.69). DWR As-Built Specification No. 64-01, Sheet No. 11, 6 November 1963, (HLM 28.69)].

View from levee crown.

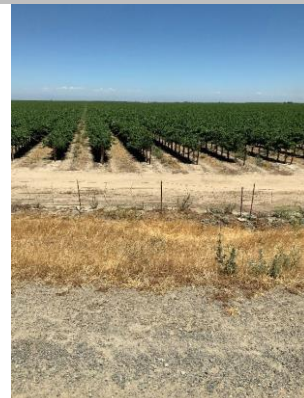
Photo 2 of 3 : UCIP_SP_2022_71074_104319.jpg

LS view from crown.

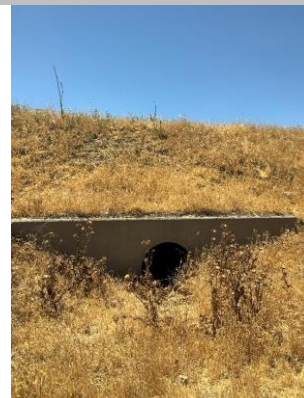
Photo 3 of 3 : UCIP_SP_2022_71074_104321.jpg

LS view from toe: concrete headwall at inlet.

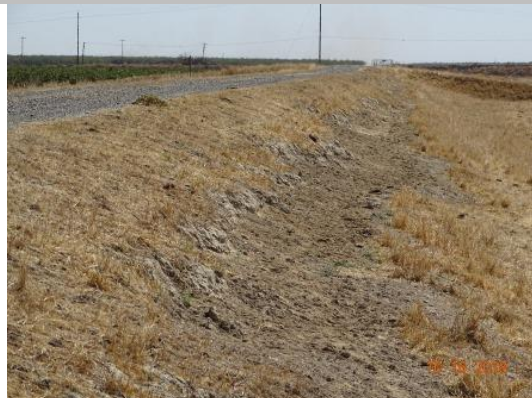
Photo 1 of 1 : SP_2022_NA0010_123_164_20220308_00053.jpg

LM Start	29.43	Rating **	M	Issue No.	164
LM End	29.56	Issue Type +	Ma	Location *	WS
Category	Earthen Levee			GPS Latitude/Longitude	
				Start	End
Item	Erosion / Livestock			37.023481 °	37.021794 °
				-120.435960 °	-120.434769 °
DWR ID	DWR_NA0010_05_f_2018_164				
Comment Code					
E4 : Repair the levee slope damaged by livestock and prevent large animal access.					
Inspector Comment					
There is slope damage on waterside from livestock traffic.

Slope damage from animal traffic. (Fall 2018)

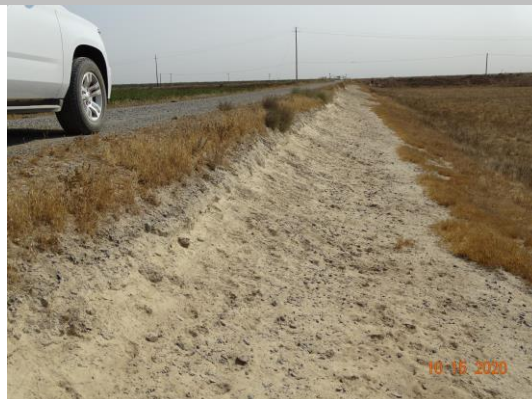
Photo 1 of 1 : SP_2022_NA0010_123_171_20220308_00058.jpg

LM Start	29.58	Rating **	U	Issue No.	171
LM End	29.80	Issue Type +	Ma	Location *	WS
Category	Earthen Levee			GPS Latitude/Longitude	
				Start	End
Item	Erosion / Livestock			37.021534 °	37.018712 °
				-120.434592 °	-120.432682 °
DWR ID	DWR_NA0010_05_s_2014_171				
Comment Code					
E4 : Repair the levee slope damaged by livestock and prevent large animal access.					
Inspector Comment					
There is waterside erosion caused by livestock.

Looking south at livestock erosion on the waterside slope. (Fall 2020)

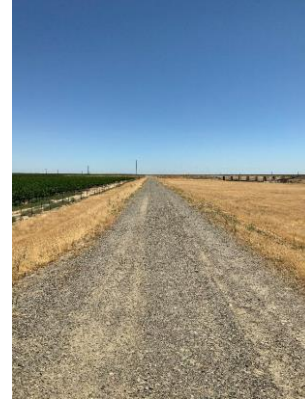
Photo 1 of 3 : UCIP_SP_2022_71076_104307.jpg

Comment Code						
Inspector Comment						
FS_ID:71076 DS_ID:19753 EP_NO: N/A Repair Type: Non-Urgent Crossing Status: Found UCIP Comments: 06/23/2021 The record remains Non-Urgent. DWR DMP internal inspection has found pipe integrity issues. LOF of crossing is between 4.1 and 5. Crossing will be monitored until funding becomes available for rehabilitation. No permit was found authorizing this encroachment. CVFPB will need to review crossing to determine owner. The UCIP inspection was completed with GEI staff, H.Dunn. (P.Espinoza ? GEI) 03/27/2014 Dense vegetation limits the inspector's visibility to identify signs of pipe failure (leaks) along the landward slope. Recommend removing vegetation along pipe alignment to conduct proper inspection of structure. Sediment buildup in pipe visible from landward side--recommend contacting owner to clear pipe. (W. Wylie - DWR UCIP) FIELD_STRUCT_DESC: 36-inch corrugated metal gravity drainage pipe (CMP) through the levee, 10.2 feet below the crown. Flap gate on the waterside (WS) end. Concrete headwall on the landside (LS) end. Concrete U-shaped headwall on the WS end. [Additional Reference(s): DWR Levee Log, 2002, (HLM 29.49). USACE San Joaquin O&M Manual, Unit No. 601, Part No. 1, 1967, Amended in 1978, Revised 20 June 1985, (HLM 29.49). DWR As-Built Specification No. 64-01, Sheet No. 12, 6 November 1963, (HLM 29.49)]. FS Date: 6/23/2021

View from levee crown.

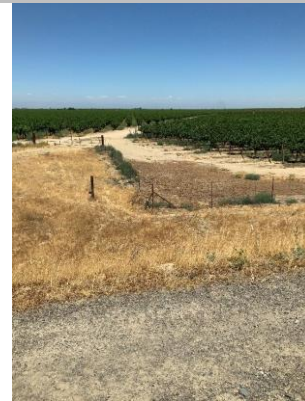
Photo 2 of 3 : UCIP_SP_2022_71076_104309.jpg

LS view from crown.

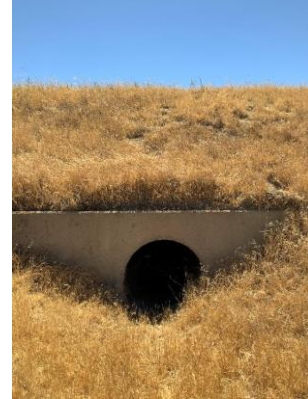
Photo 3 of 3 : UCIP_SP_2022_71076_104311.jpg

LS view from toe: concrete headwall at inlet.

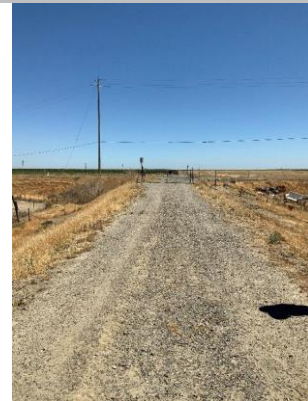
Photo 1 of 3 : UCIP_SP_2022_71087_104303.jpg

FS_ID:71087
 DS_ID:19754
 EP_NO: N/A
 Repair Type: Non-Urgent
 Crossing Status: Found
 UCIP Comments: 06/23/2021 The record remains Non-Urgent.
 Crossing appears to be in good condition. No permit was found authorizing this encroachment. CVFPB will need to review crossing to determine owner. The UCIP inspection was completed with GEI staff, H.Dunn. (P.Espinoza ? GEI) 03/27/2014 Dense vegetation limits the inspector's visibility to identify signs of pipe failure (leaks) along the landward slope. Recommend removing vegetation along pipe alignment to conduct proper inspection of structure. (W. Wylie - DWR UCIP)
 FIELD_STRUCT_DESC: 30-inch by 30-inch reinforced concrete box gravity drainage culvert (RCBC) through the levee, 12.0 feet below the crown. Flap gate on the waterside (WS) end. Concrete headwall on the landside (LS) end. Concrete U-shaped headwall on the WS end.
 [Additional Reference(s): DWR Levee Log, 2002, (HLM 29.72). USACE San Joaquin O&M Manual, Unit No. 601, Part No. 1, 1967, Amended in 1978, Revised 20 June 1985, (HLM 29.72). DWR As-Built Specification No. 64-42, Sheet No. 6, 13 August 1964, (HLM 29.72)].

View from levee crown.

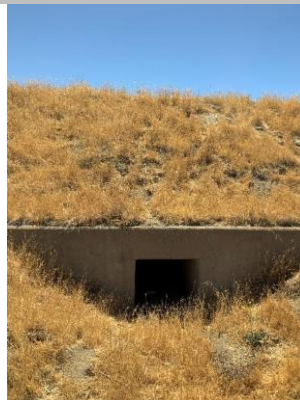
Photo 2 of 3 : UCIP_SP_2022_71087_104305.jpg

LS view from toe: concrete headwall at inlet.

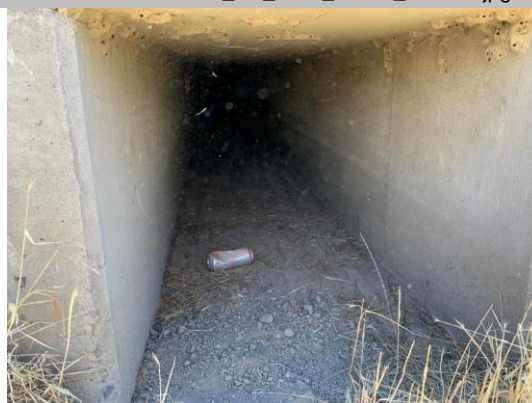
Photo 3 of 3 : UCIP_SP_2022_71087_104306.jpg

LS view from toe: inside of inlet.

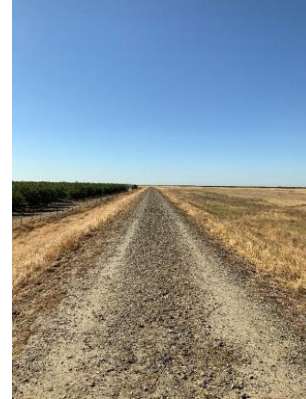
Photo 1 of 3 : UCIP_SP_2022_71078_104296.jpg

Comment Code					
Inspector Comment					
FS_ID:71078 DS_ID:19696 EP_NO: N/A Repair Type: Non-Urgent Crossing Status: Found UCIP Comments: 06/24/2021 The record remains Non-Urgent. Limited inspection of LS due to dense vegetation; recommend removal. No permit was found authorizing this encroachment. CVFPB will need to review crossing to determine owner. The UCIP inspection was completed with GEI staff, H.Dunn. (P.Espinoza ? GEI) 03/27/2014 Dense vegetation limits the inspector's visibility to identify signs of pipe failure (leaks) along the landward slope. Recommend removing vegetation along pipe alignment to conduct proper inspection of structure. (W. Wylie - DWR UCIP) FIELD_STRUCT_DESC: 30-inch by 30-inch reinforced concrete box gravity drainage culvert (RCBC) through the levee, 13.1 feet below the crown. Flap gate on the waterside (WS) end. Concrete headwall on the landside (LS) end. Concrete U-shaped headwall on the WS end. [Additional Reference(s): DWR Levee Log, 2002, (HLM 30.04). USACE San Joaquin O&M Manual, Unit No. 601, Part No. 1, 1967, Amended in 1978, Revised 20 June 1985, (HLM 30.04). DWR As-Built Specification No. 64-42, Sheet No. 6, 13 August 1964, (HLM 30.04)]. FS Date: 6/24/2021

View from levee crown.

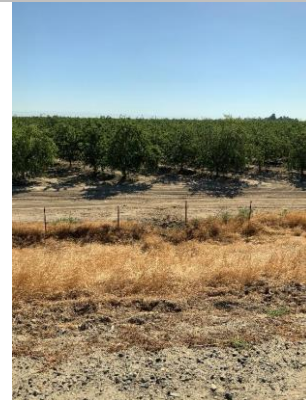
Photo 2 of 3 : UCIP_SP_2022_71078_104297.jpg

LS view from crown.

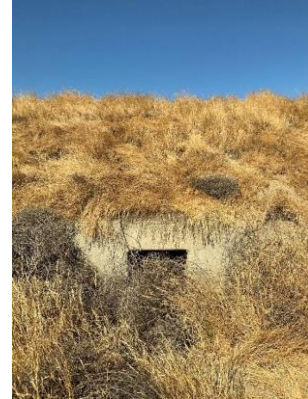
Photo 3 of 3 : UCIP_SP_2022_71078_104301.jpg

LS view from toe: concrete headwall at inlet.

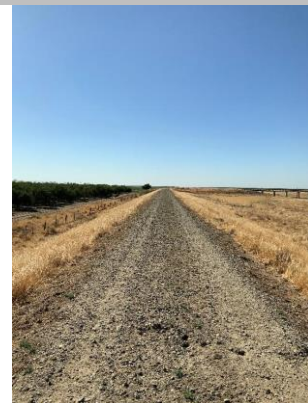
Photo 1 of 3 : UCIP_SP_2022_71079_104289.jpg

FS_ID:71079
DS_ID:19697
EP_NO: N/A
Repair Type: Non-Urgent
Crossing Status: Found
UCIP Comments: 06/24/2021 The record remains Non-Urgent.
Crossing appears to be in good condition. No permit was found authorizing this encroachment. CVFPB will need to review crossing to determine owner. The UCIP inspection was completed with GEI staff, H.Dunn. (P.Espinoza ? GEI) 03/27/2014 Some debris buildup at LS toe. Dense vegetation limits the inspector's visibility to identify signs of pipe failure (leaks) along the landward slope. Recommend removing vegetation along pipe alignment to conduct proper inspection of structure. (W. Wylie - DWR UCIP)
FIELD_STRUCT_DESC: 30-inch by 30-inch reinforced concrete box gravity drainage culvert (RCBC) through the levee, 13.3 feet below the crown. Flap gate on the waterside (WS) end. Concrete headwall on the landside (LS) end. Concrete U-shaped headwall on the WS end.
[Additional Reference(s): DWR Levee Log, 2002, (HLM 30.97). USACE San Joaquin O&M Manual, Unit No. 601, Part No. 1, 1967, Amended in 1978, Revised 20 June 1985, (HLM 30.96). DWR As-Built Specification No. 64-42, Sheet No. 7, 13 August 1964, (HLM 30.96)].

Levee crown.

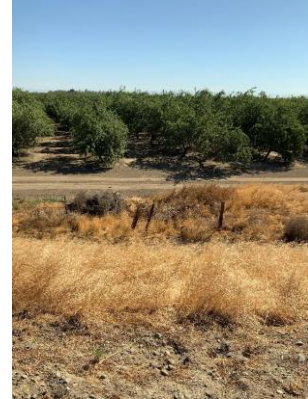
Photo 2 of 3 : UCIP_SP_2022_71079_104291.jpg

LS view from crown.

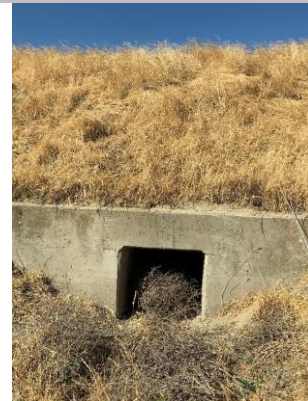
Photo 3 of 3 : UCIP_SP_2022_71079_104294.jpg

LS view from toe: concrete headwall at inlet.

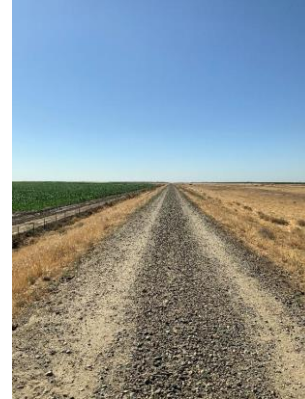
Photo 1 of 3 : UCIP_SP_2022_71080_104282.jpg

Comment Code					
Inspector Comment					
FS_ID:71080 DS_ID:19698 EP_NO: N/A Repair Type: Non-Urgent Crossing Status: Found UCIP Comments: 06/24/2021 The record remains Non-Urgent. Some tumbleweed buildup over WS flapgate and LS inlet, recommend removal. No permit was found authorizing this encroachment. CVFPB will need to review crossing to determine owner. The UCIP inspection was completed with GEI staff, H.Dunn. (P.Espinoza ? GEI)					
03/27/2014 Excess vegetation buildup at inlet on LS toe. Dense vegetation limits the inspector's visibility to identify signs of pipe failure (leaks) along the landward slope. Recommend removing vegetation along pipe alignment to conduct proper inspection of structure. (W. Wylie - DWR UCIP)					
FIELD_STRUCT_DESC: 30-inch by 30-inch reinforced concrete box gravity drainage culvert (RCBC) through the levee, 13.4 feet below the crown. Flap gate on the waterside (WS) end. Concrete headwall on the landside (LS) end. Concrete U-shaped headwall on the WS end.

View from levee crown.

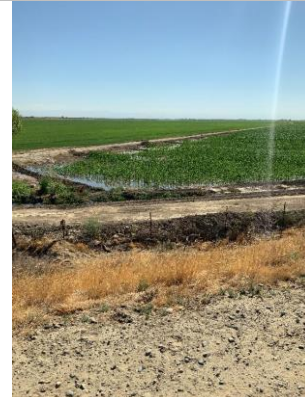
Photo 2 of 3 : UCIP_SP_2022_71080_104283.jpg

View of LS from crown.

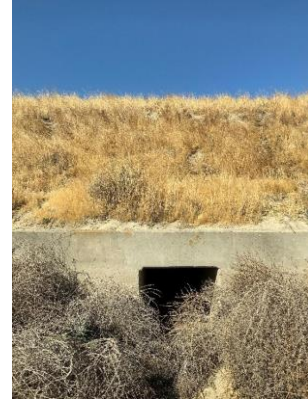
Photo 3 of 3 : UCIP_SP_2022_71080_104285.jpg

LS view from toe: concrete headwall at inlet.

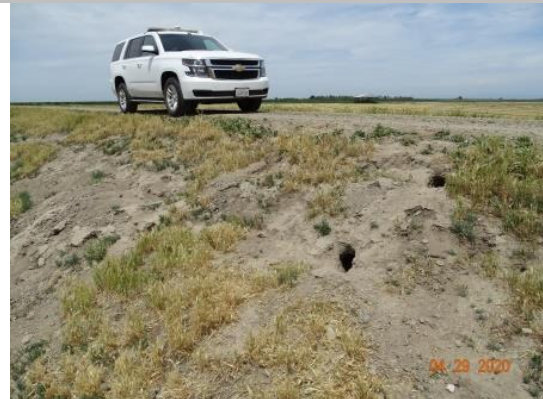
Photo 1 of 1 : SP_2022_NA0010_123_230_20220308_00064.jpg

LM Start	31.66	Rating **	U	Issue No.	230
LM End	31.66	Issue Type +	Ma	Location *	WS
Category	Earthen Levee			GPS Latitude/Longitude	
				Start	End
Item	Animal Control			36.997828 °	36.997828 °
				-120.411920 °	-120.411920 °
DWR ID	DWR_NA0010_05_s_2020_230				
Comment Code					
A3 : No rodents visible, but rodent burrows visible; need to backfill and compact or grout burrows.					
Inspector Comment					
Several rodent burrows in the waterside slope and shoulder.

Rodent burrows in the waterside slope. (Spring 2020)
