**Flood Control Project Maintenance
Levee Inspections**

Maintenance Issue Types Only, Levee Inspection Report By Mile - Spring 2022

Lower San Joaquin Levee District

Waterway	Bank	Unit Miles	Inspection Start/End	Inspector
Unit No. 01 San Joaquin River	Right	22.52	04/05/2022 04/05/2022	Corey Fujitani

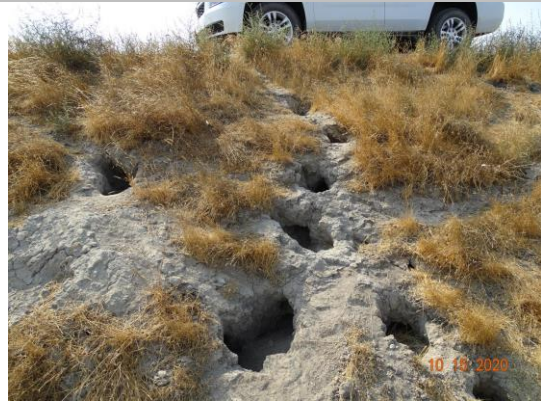
Photo 1 of 1 : SP_2022_NA0010_123_129_20220308_00029.jpg

LM Start	31.70	Rating **	U	Issue No.	129
LM End	31.73	Issue Type +	Ma	Location *	LS
Category	Earthen Levee			GPS Latitude/Longitude	
				Start	End
Item	Animal Control			36.997410 °	36.997108 °
				-120.411437 °	-120.411092 °
DWR ID	DWR_NA0010_05_f_2020_129				
Comment Code					
A3 : No rodents visible, but rodent burrows visible; need to backfill and compact or grout burrows.					
Inspector Comment

Several large rodent holes noted at this location. (Fall 2020)

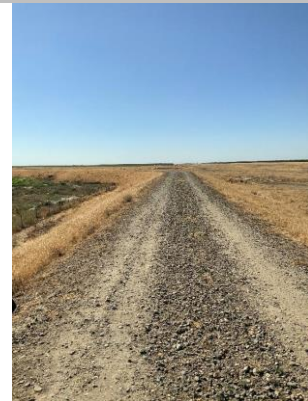
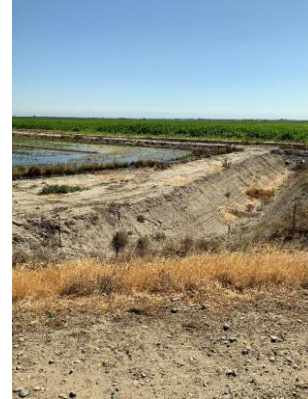
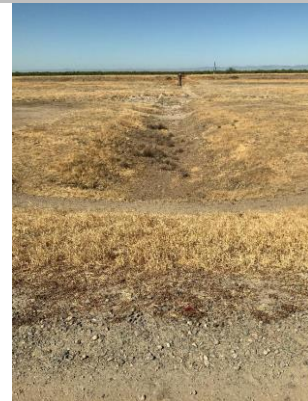
Comment Code						
Inspector Comment						
FS_ID:71081 DS_ID:19699 EP_NO: N/A Repair Type: Non-Urgent Crossing Status: Found UCIP Comments: 06/24/2021 The record has been upgraded from No Action Needed to Non-Urgent. Limited inspection of LS due to dense vegetation; recommend removal. Wooden planks propping flapgate on WS open; recommend removal before flood season. No permit was found authorizing this encroachment. CVFPB will need to review crossing to determine owner. The UCIP inspection was completed with GEI staff, H.Dunn. (P.Espinoza ? GEI) FIELD_STRUCT_DESC: 48-inch by 36-inch reinforced concrete box gravity drainage culvert (RCBC) through the levee, 14.5 feet below the crown. Flap gate on the waterside (WS) end. Concrete U-shaped headwall on each end. [Additional Reference(s): DWR Levee Log, 2002, (HLM 31.64). USACE San Joaquin O&M Manual, Unit No. 601, Part No. 1, 1967, Amended in 1978, Revised 20 June 1985, (HLM 31.64). DWR As-Built Specification No. 64-42, Sheet No. 8, 13 August 1964, (HLM 31.64)]. FS Date: 6/24/2021 2:15:00 PM

View from levee crown.

LS view from crown.

WS view from crown.

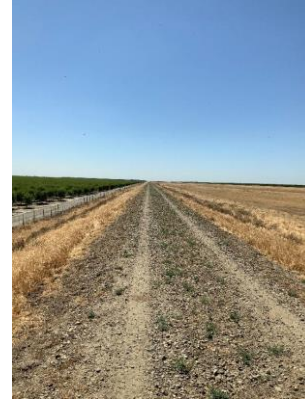
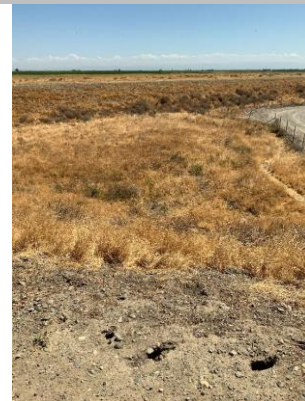
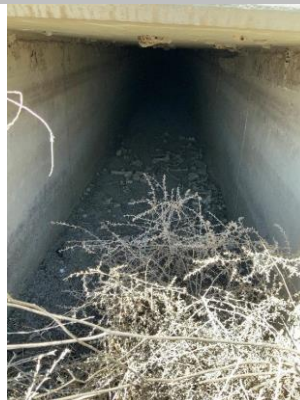
Comment Code						
Inspector Comment						
FS_ID:71082 DS_ID:19700 EP_NO: N/A Repair Type: Non-Urgent Crossing Status: Found UCIP Comments: 06/23/2021 The record remains Non-Urgent. Some tumbleweed buildup at LS inlet and WS flapgate, recommend removal. No permit was found authorizing this encroachment. CVFPB will need to review crossing to determine owner. The UCIP inspection was completed with GEI staff, H.Dunn. (P.Espinoza ? GEI) 04/01/2014 Dense vegetation limits the inspector's visibility to identify signs of pipe failure (leaks) along the landward slope. Recommend removing vegetation along pipe alignment to conduct proper inspection of structure. (W. Wylie - DWR UCIP) FIELD_STRUCT_DESC: 30-inch by 30-inch reinforced concrete box gravity drainage culvert (RCBC) through the levee, 13.0 feet below the crown. Flap gate on the waterside (WS) end. Concrete headwall on the landside (LS) end with flashboard attachment. Concrete U-shaped headwall on the WS end. [Additional Reference(s): DWR Levee Log, 2002, (HLM 31.69). USACE San Joaquin O&M Manual, Unit No. 601, Part No. 1, 1967, Amended in 1978, Revised 20 June 1985, (HLM 31.71). DWR As-Built Specification No. 64-42, Sheet No. 8, 13 August 1964, (HLM 31.71)]. FS Date: 6/23/2021 2:03:00 PM

View from levee crown.

LS view from crown.

LS view: inside view of inlet.

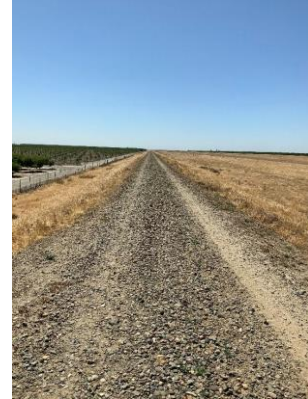
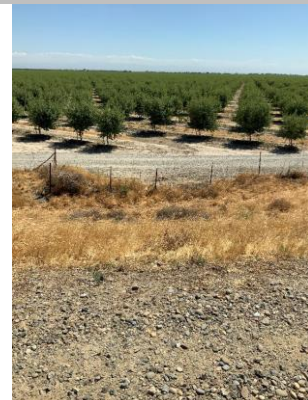
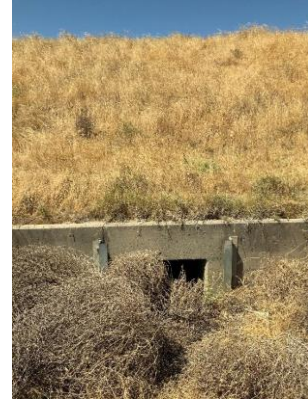
Comment Code					
Inspector Comment					
FS_ID:71083 DS_ID:19701 EP_NO: N/A Repair Type: Non-Urgent Crossing Status: Found UCIP Comments: 06/23/2021 The record remains Non-Urgent. Limited inspection of LS inlet due to dense vegetation; recommend removal. No permit was found authorizing this encroachment. CVFPB will need to review crossing to determine owner. The UCIP inspection was completed with GEI staff, H.Dunn. (P.Espinoza ? GEI) 04/01/2014 Some silt buildup inside culvert. (W. Wylie - DWR UCIP) FIELD_STRUCT_DESC: 30-inch by 30-inch reinforced concrete box gravity drainage culvert (RCBC) through the levee, 14.2 feet below the crown. Flap gate on the waterside (WS) end. Concrete headwall on the landside (LS) end with flashboard attachment. Concrete U-shaped headwall on the WS end. [Additional Reference(s): DWR Levee Log, 2002, (HLM 32.22). USACE San Joaquin O&M Manual, Unit No. 601, Part No. 1, 1967, Amended in 1978, Revised 20 June 1985, (HLM 32.22). DWR As-Built Specification No. 64-42, Sheet No. 8, 13 August 1964, (HLM 32.22)]. FS Date: 6/23/2021 1:18:00 PM

View from levee crown.

LS view from crown.

LS view from toe: concrete headwall at inlet.

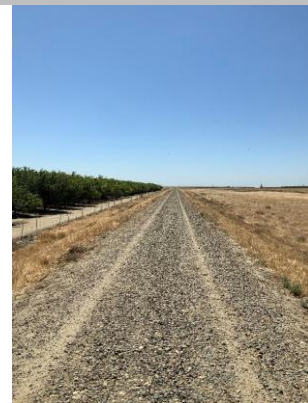
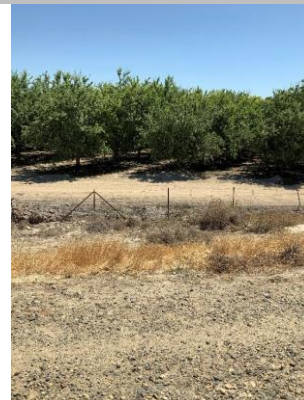
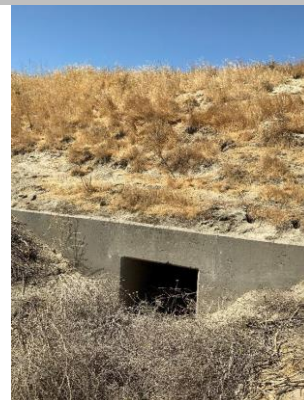
UCIP Comments: 06/23/2021 The record remains Non-Urgent. Some tumbleweed buildup over WS flapgate and LS inlet, recommend removal. No permit was found authorizing this encroachment. CVFPB will need to review crossing to determine owner. The UCIP inspection was completed with GEI staff, H.Dunn. (P.Espinoza ? GEI)

04/01/2014 Dense vegetation limits the inspector's visibility to identify signs of pipe failure (leaks) along the landward slope. Recommend removing vegetation along pipe alignment to conduct proper inspection of structure. Debris buildup blocking landward headwall--recommend contacting owner to clear debris. (W. Wylie - DWR UCIP)

View from levee crown.

LS view from crown.

LS view from toe: concrete headwall at inlet.

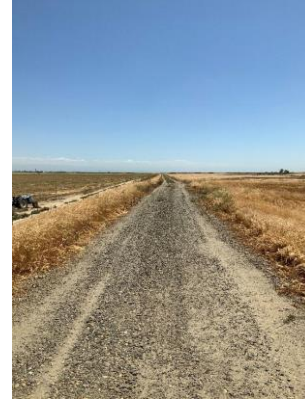
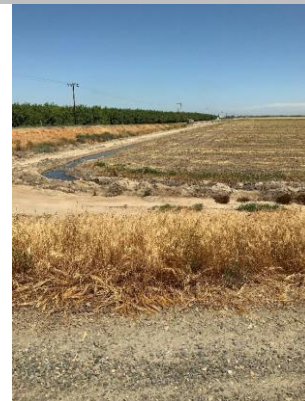
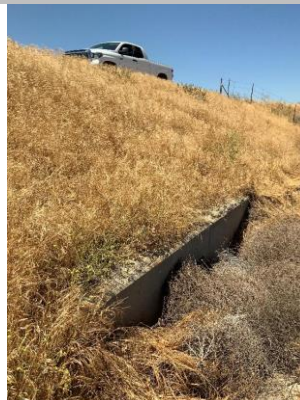
Comment Code					
Inspector Comment					
FS_ID:71085 DS_ID:19703 EP_NO: N/A Repair Type: Non-Urgent Crossing Status: Found UCIP Comments: 06/24/2021 The record remains Non-Urgent. Limited inspection of LS and WS due to dense vegetation; recommend removal. No permit was found authorizing this encroachment. CVFPB will need to review crossing to determine owner. The UCIP inspection was completed with GEI staff, H.Dunn. (P.Espinoza ? GEI) 04/01/2014 Dense vegetation limits the inspector's visibility to identify signs of pipe failure (leaks) along the slopes. Recommend removing vegetation along pipe alignment to conduct proper inspection of structure. (W. Wylie - DWR UCIP) FIELD_STRUCT_DESC: 30-inch by 30-inch reinforced concrete box gravity drainage culvert (RCBC) through the levee, 13.9 feet below the crown. Flap gate on the waterside (WS) end. Concrete headwall on the landside (LS) end. Concrete U-shaped headwall on the WS end. [Additional Reference(s): DWR Levee Log, 2002, (HLM 33.72). USACE San Joaquin O&M Manual, Unit No. 601, Part No. 1, 1967, Amended in 1978, Revised 20 June 1985, (HLM 33.72). DWR As-Built Specification No. 64-42, Sheet No. 9, 13 August 1964, (HLM 33.72)]. FS Date: 6/24/2021 12:30:00 PM

View from levee crown.

LS view from crown.

LS view from toe: concrete headwall and inlet.

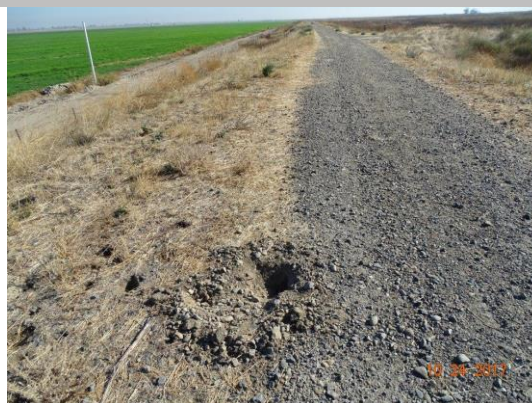
Photo 1 of 1 : SP_2022_NA0010_123_130_20220308_00030.jpg

LM Start	33.82	Rating **	M	Issue No.	130
LM End	33.82	Issue Type +	Ma	Location *	LS
Category	Earthen Levee			GPS Latitude/Longitude	
				Start	End
Item	Animal Control			36.976849 °	36.976849 °
				-120.382393 °	-120.382393 °
DWR ID	DWR_NA0010_05_f_2017_130				
Comment Code					
A3 : No rodents visible, but rodent burrows visible; need to backfill and compact or grout burrows.					
Inspector Comment

Looking east at the landside shoulder.

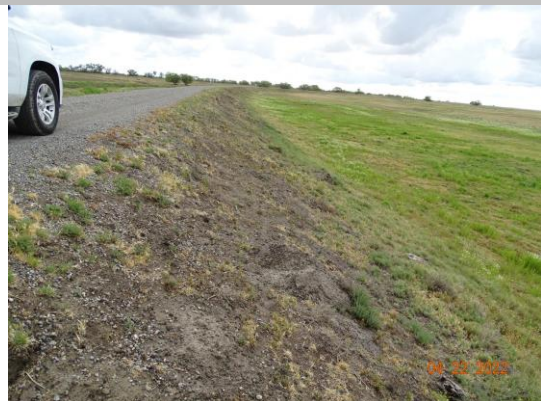
Photo 1 of 1 : SP_2022_NA0010_124_147_20220425_00228.jpg

LM Start	0.14	Rating **	M	Issue No.	147
LM End	0.14	Issue Type +	Ma	Location *	LS
Category	Earthen Levee			GPS Latitude/Longitude	
				Start	End
Item	Animal Control			37.275637 °	37.275637 °
				-120.823438 °	-120.823438 °
DWR ID	DWR_NA0010_06_s_2022_147				
Comment Code					
A3 : No rodents visible, but rodent burrows visible; need to backfill and compact or grout burrows.					
Inspector Comment

View of rodent burrows on the landside slope. (Spring 2022)

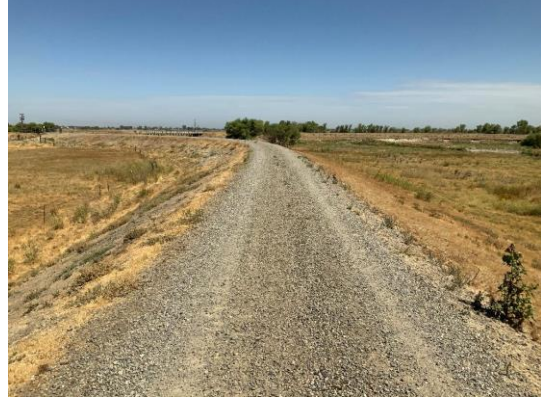
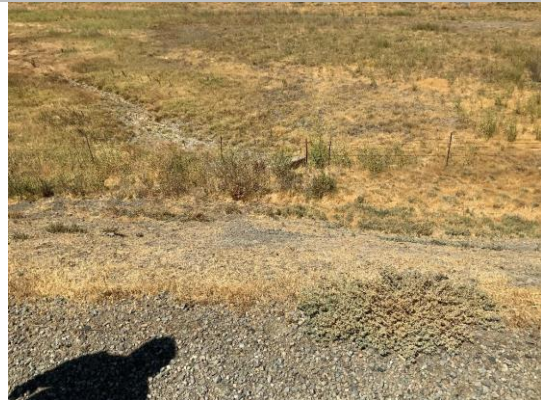
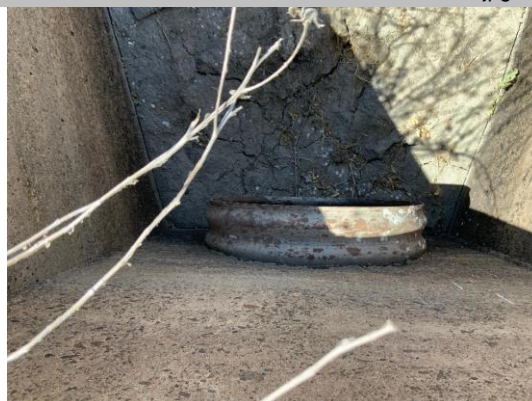
Comment Code						
Inspector Comment						
FS_ID:71092 DS_ID:19816 EP_NO: N/A Repair Type: Non-Urgent Crossing Status: Found UCIP Comments: 07/27/2021 The record remains Non-Urgent. LS pipe inlet is blocked by barbed wire, limited access and inspection. No permit was found authorizing this encroachment. CVFPB will need to review crossing to determine owner. The UCIP inspection was completed with GEI staff, P. Espinoza. (H. Dunn ? GEI) 04/18/2014 Landward side blocked--need to contact owner to determine status of crossing. (O. Magana - DWR UCIP) FIELD_STRUCT_DESC: 24-inch corrugated metal gravity drainage pipe (CMP) through the levee, 16.2 feet below the crown. Flap gate on the waterside (WS) end. Concrete U-shaped headwall on each end. [Additional Reference(s): DWR Levee Log, 2002, (HLM 0.86). USACE San Joaquin O&M Manual, Unit No. 601, Part No. 1, 1967, Amended in 1978, Revised 20 June 1985, (HLM 0.86). DWR As-Built Specification No. 61-01, Sheet No. 45, 7 March 1961, (HLM 0.86)]. FS Date: 7/27/2021

Levee crown.

LS view: Toe from crown.

LS view: Top view of pipe inlet at toe.

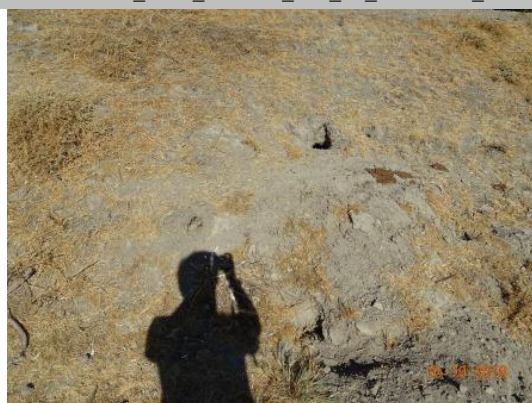
Photo 1 of 1 : SP_2022_NA0010_124_93_20220308_00027.jpg

LM Start	1.18	Rating **	U	Issue No.	93
LM End	1.18	Issue Type +	Ma	Location *	LS
Category	Earthen Levee			GPS Latitude/Longitude	
				Start	End
Item	Animal Control			37.267101 °	37.267101 °
				-120.809603 °	-120.809603 °
DWR ID	DWR_NA0010_06_f_2018_93				
Comment Code					
A1 : Exterminate rodents and backfill and compact or grout burrows.					
Inspector Comment					
Several rodent burrows including large burrows were observed at this location.

View of landside slope. (Fall 2018)

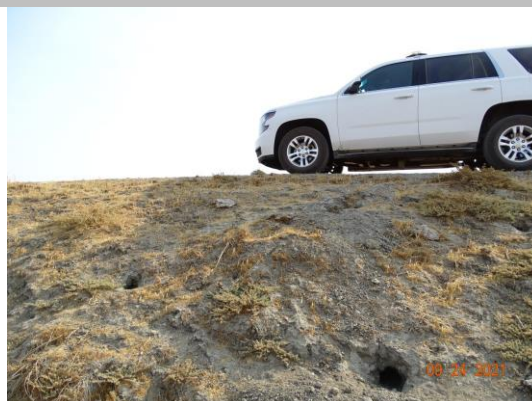
Photo 1 of 1 : SP_2022_NA0010_124_127_20220308_00047.jpg

LM Start	1.52	Rating **	M	Issue No.	127
LM End	1.52	Issue Type +	Ma	Location *	LS
Category	Earthen Levee			GPS Latitude/Longitude	
				Start	End
Item	Animal Control			37.263176 °	37.263176 °
				-120.805983 °	-120.805983 °
DWR ID	DWR_NA0010_06_f_2021_127				
Comment Code					
A3 : No rodents visible, but rodent burrows visible; need to backfill and compact or grout burrows.					
Inspector Comment

View of rodent burrows in the landside slope. (Fall 2021)

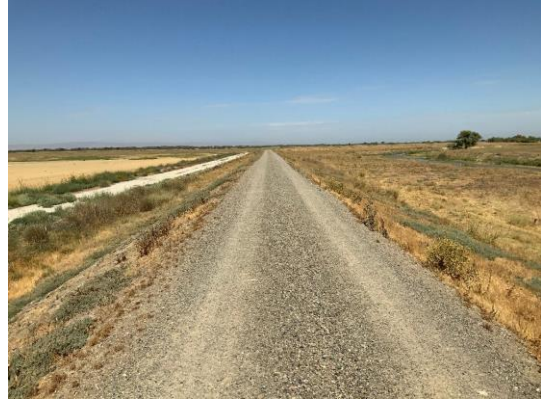
Photo 1 of 3 : UCIP_SP_2022_71093_102901.jpg

Comment Code					
Inspector Comment					
FS_ID:71093 DS_ID:19817 EP_NO: N/A Repair Type: Non-Urgent Crossing Status: Found UCIP Comments: 07/27/2021 The record remains Non-Urgent. LS pipe inlet inaccessible due to barbed wire and not visible due to dense vegetation, limited inspection and recommend removing vegetation. No permit was found authorizing this encroachment. CVFPB will need to review crossing to determine owner. The UCIP inspection was completed with GEI staff, P. Espinoza. (H. Dunn ? GEI) 04/18/2014 No access was available to landward side due to fence. Recommend removing some of the vegetation on waterward toe. (O. Magana - DWR UCIP) FIELD_STRUCT_DESC: 24-inch corrugated metal gravity drainage pipe (CMP) through the levee, 13.5 feet below the crown. Flap gate on the waterside (WS) end. Concrete headwall on each end. [Additional Reference(s): DWR Levee Log, 2002, (HLM 1.96). USACE San Joaquin O&M Manual, Unit No. 601, Part No. 1, 1967, Amended in 1978, Revised 20 June 1985, (HLM 1.95). DWR As-Built Specification No. 61-01, Sheet No. 46, 7 March 1961, (HLM 1.95)]. FS Date: 7/27/2021

Levee crown.

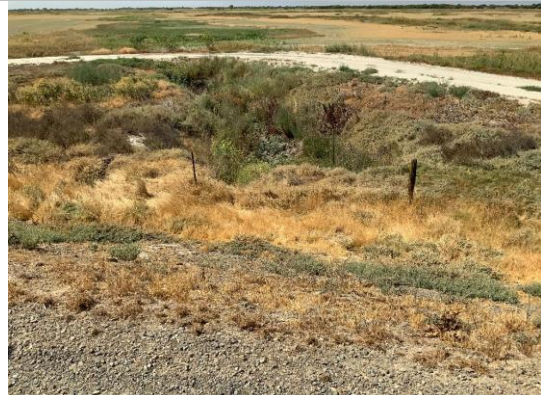
Photo 2 of 3 : UCIP_SP_2022_71093_102902.jpg

LS view: Toe from crown.

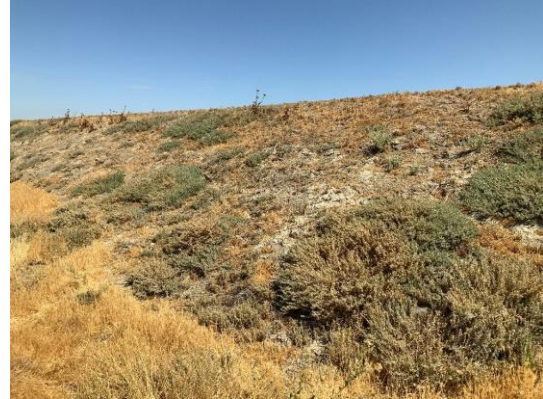
Photo 3 of 3 : UCIP_SP_2022_71093_102903.jpg

LS view: Slope from toe.

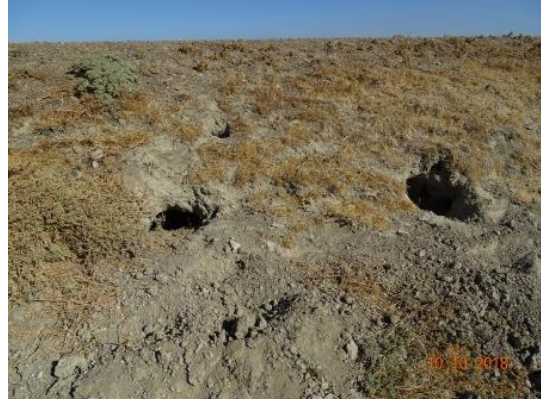
Photo 1 of 1 : SP_2022_NA0010_124_92_20220308_00026.jpg

LM Start	2.42	Rating **	U	Issue No.	92
LM End	2.42	Issue Type +	Ma	Location *	LS
Category	Earthen Levee			GPS Latitude/Longitude	
				Start	End
Item	Animal Control			37.254519 °	37.254519 °
				-120.795141 °	-120.795141 °
DWR ID	DWR_NA0010_06_f _ 2018_92				
Comment Code					
A3 : No rodents visible, but rodent burrows visible; need to backfill and compact or grout burrows.					
Inspector Comment

View of large rodent holes in landside slope. (Fall 2018)

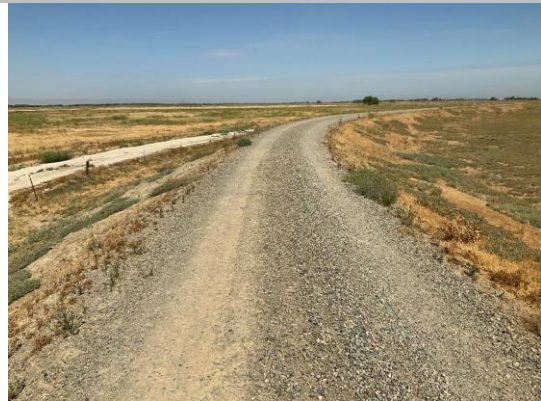
Photo 1 of 3 : UCIP_SP_2022_71094_102913.jpg

Comment Code					
Inspector Comment					
FS_ID:71094 DS_ID:19818 EP_NO: N/A Repair Type: Non-Urgent Crossing Status: Found UCIP Comments: 07/27/2021 The record remains Non-Urgent. DWR DMP internal inspection has found pipe integrity issues. LOF of crossing is between 4.1 and 5. Crossing will be monitored until funding becomes available for rehabilitation. No permit was found authorizing this encroachment. CVFPB will need to review crossing to determine owner. The UCIP inspection was completed with GEI staff, P. Espinoza. (H. Dunn ? GEI) 04/18/2014 Need to contact owner. Sediment buildup in pipe visible on landward side. (O. Magana - DWR UCIP) FIELD_STRUCT_DESC: 36-inch corrugated metal gravity drainage pipe (CMP) through the levee, 6.9 feet below the crown. Slide gate in a 48-inch CMP riser unit on the waterside (WS) slope. Concrete headwall on each end. [Additional Reference(s): DWR Levee Log, 2002, (HLM 2.61). USACE San Joaquin O&M Manual, Unit No. 601, Part No. 1, 1967, Amended in 1978, Revised 20 June 1985, (HLM 2.61). DWR As-Built Specification No. 61-01, Sheet No. 46, 7 March 1961, (HLM 2.61)]. FS Date: 7/27/2021

Levee crown.

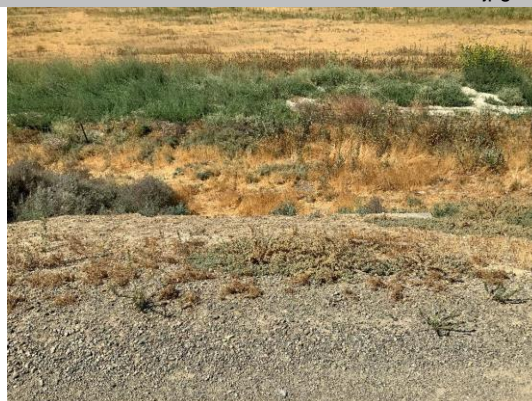
Photo 2 of 3 : UCIP_SP_2022_71094_102914.jpg

LS view: Headwall visible at toe from crown.

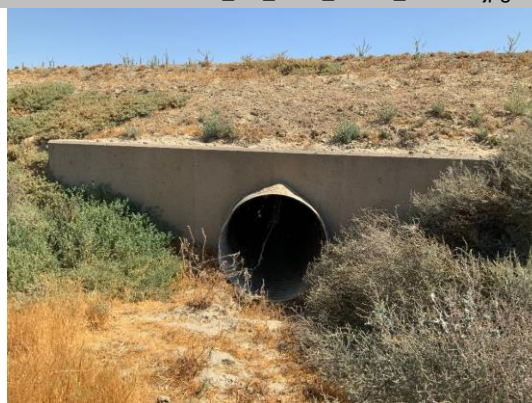
Photo 3 of 3 : UCIP_SP_2022_71094_102915.jpg

LS view: Headwall and slope from toe.

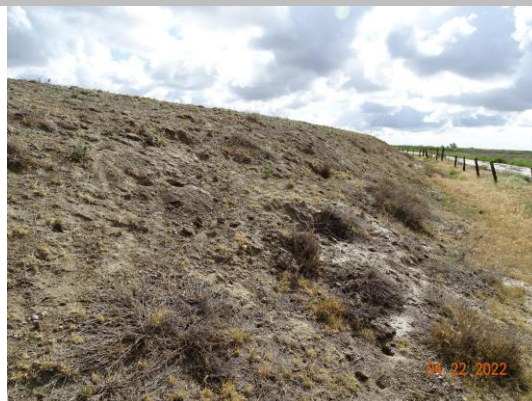
Photo 1 of 1 : SP_2022_NA0010_124_76_20220425_00231.jpg

LM Start	2.54	Rating **	M	Issue No.	76
LM End	2.54	Issue Type +	Ma	Location *	LS
Category	Earthen Levee			GPS Latitude/Longitude	
				Start	End
Item	Animal Control			37.252874 °	37.252874 °
				-120.794192 °	-120.794192 °
DWR ID	DWR_NA0010_06_f_2016_76				
Comment Code					
A3 : No rodents visible, but rodent burrows visible; need to backfill and compact or grout burrows.					
Inspector Comment					
There are several rodent burrows in the landside slope at this location.

View of rodent holes on the landside slope looking upstream. (Spring 2022)

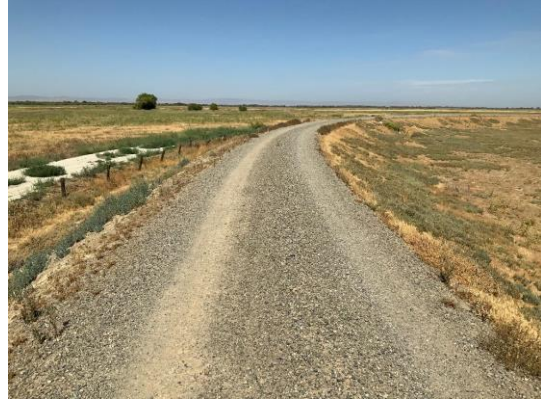
Photo 1 of 3 : UCIP_SP_2022_71095_102919.jpg

Comment Code						
Inspector Comment						
FS_ID:71095 DS_ID:19819 EP_NO: N/A Repair Type: Non-Urgent Crossing Status: Found UCIP Comments: 07/27/2021 The record remains Non-Urgent. DWR DMP internal inspection has found pipe integrity issues. LOF of crossing is between 4.1 and 5. Crossing will be monitored until funding becomes available for rehabilitation. Dense vegetation covering LS pipe inlet, limited inspection and recommend removal. No permit was found authorizing this encroachment. CVFPB will need to review crossing to determine owner. The UCIP inspection was completed with GEI staff, P. Espinoza. (H. Dunn ? GEI) 04/18/2014 Dense vegetation limits the inspector's visibility to identify signs of pipe condition on landward toe--headwall blocked by dense vegetation. Recommend removing vegetation from landward toe. (O. Magana - DWR UCIP) FIELD_STRUCT_DESC: 24-inch corrugated metal gravity drainage pipe (CMP) through the levee, 9.2 feet below the crown. Flap gate on the waterside (WS) end. Concrete headwall on each end. [Additional Reference(s): DWR Levee Log, 2002, (HLM 2.65). USACE San Joaquin O&M Manual, Unit No. 601, Part No. 1, 1967, Amended in 1978, Revised 20 June 1985, (HLM 2.65). DWR As-Built Specification No. 61-01, Sheet No. 46, 7 March 1961, (HLM 2.65)]. FS Date: 7/27/2021

Levee crown.

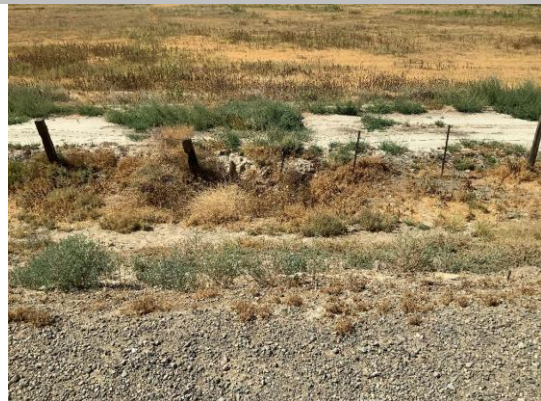
Photo 2 of 3 : UCIP_SP_2022_71095_102920.jpg

LS view: Toe from crown.

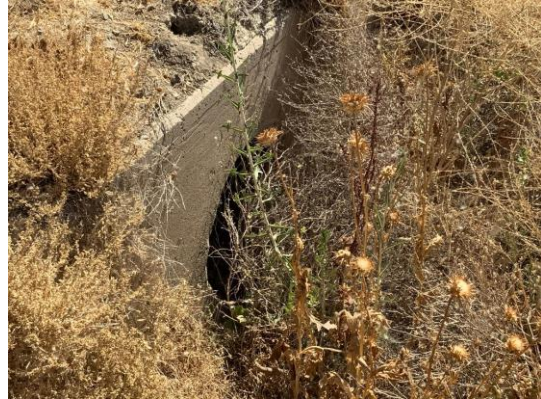
Photo 3 of 3 : UCIP_SP_2022_71095_102921.jpg

LS view: Closeup of pipe inlet at toe with dense vegetation.

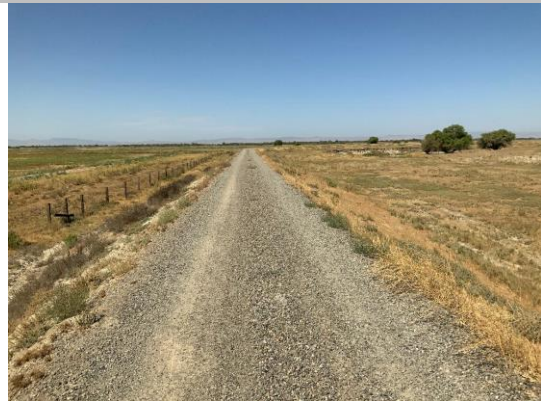
Photo 1 of 3 : UCIP_SP_2022_71096_102928.jpg

FS_ID:71096
DS_ID:19820
EP_NO: N/A
Repair Type: Urgent
Crossing Status: Found
UCIP Comments: 07/27/2021 The record has been upgraded from Non-Urgent to Urgent. DWR DMP internal inspection has found pipe integrity issues. LOF of crossing is greater than or equal to 5 and less than 6. Crossing will be monitored until funding becomes available to address the issues. Dense vegetation covering LS pipe inlet, limited inspection and recommend removal of vegetation. Some minor erosion under WS concrete pad, less than a foot in length. No permit was found authorizing this encroachment. CVFPB will need to review crossing to determine owner. The UCIP inspection was completed with GEI staff, P. Espinoza. (H. Dunn ? GEI) 04/18/2014 Dense vegetation limits the inspector's visibility to identify signs of pipe condition on landward toe-headwall blocked by dense vegetation. Recommend removing vegetation from landward toe. (O. Magana - DWR UCIP)

FIELD_STRUCT_DESC: 24-inch corrugated metal gravity drainage pipe (CMP) through the levee, 10.5 feet below the crown. Flap gate on the waterside (WS) end. Concrete headwall on each end. [Additional Reference(s): DWR Levee Log, 2002, (HLM 2.85). USACE San Joaquin O&M Manual, Unit No. 601, Part No. 1, 1967, Amended in 1978, Revised 20 June 1985, (HLM 2.85). DWR As-Built Specification No. 61-01, Sheet No. 47, 7 March 1961, (HLM 2.85)].
FS Date: 7/27/2021

Levee crown.

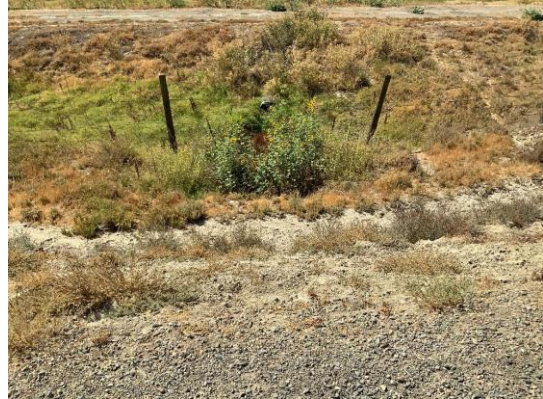
Photo 2 of 3 : UCIP_SP_2022_71096_102929.jpg

LS view: Toe from crown.

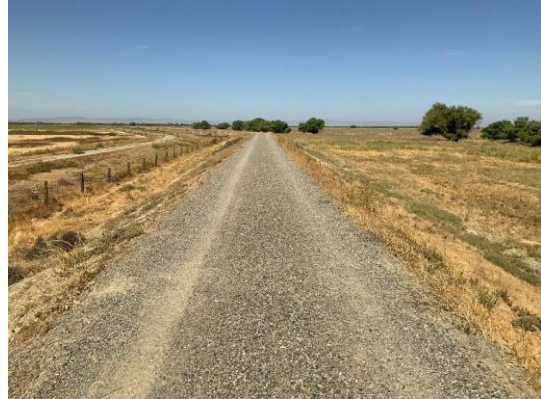
Photo 1 of 3 : UCIP_SP_2022_71097_102944.jpg

Comment Code						
Inspector Comment						
FS_ID:71097 DS_ID:19821 EP_NO: N/A Repair Type: Non-Urgent Crossing Status: Found UCIP Comments: 07/27/2021 The record remains Non-Urgent. Limited inspection due to sediment and debris buildup inside LS pipe inlet, recommend removal. Sediment buildup keeping WS flapgate open, recommend removal. No permit was found authorizing this encroachment. CVFPB will need to review crossing to determine owner. The UCIP inspection was completed with GEI staff, P. Espinoza. (H. Dunn ? GEI) 04/18/2014 Dense vegetation limits the inspector's visibility to identify signs of pipe condition on landward toe--headwall blocked by dense vegetation. Recommend removing vegetation from landward toe. (O. Magana - DWR UCIP) FIELD_STRUCT_DESC: 24-inch corrugated metal gravity drainage pipe (CMP) through the levee, 11.2 feet below the crown. Flap gate on the waterside (WS) end. Concrete headwall on each end. [Additional Reference(s): DWR Levee Log, 2002, (HLM 3.09). USACE San Joaquin O&M Manual, Unit No. 601, Part No. 1, 1967, Amended in 1978, Revised 20 June 1985, (HLM 3.09). DWR As-Built Specification No. 61-01, Sheet No. 47, 7 March 1961, (HLM 3.09)]. FS Date: 7/27/2021

Levee crown.

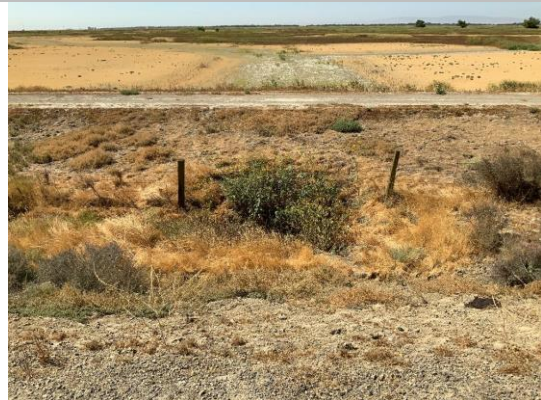
Photo 2 of 3 : UCIP_SP_2022_71097_102945.jpg

LS view: Toe from crown.

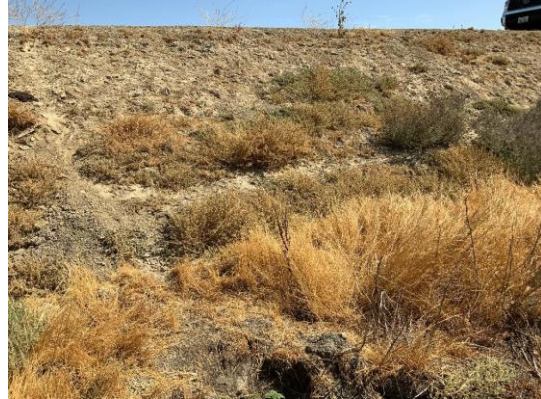
Photo 3 of 3 : UCIP_SP_2022_71097_102946.jpg

LS view: Slope from toe.

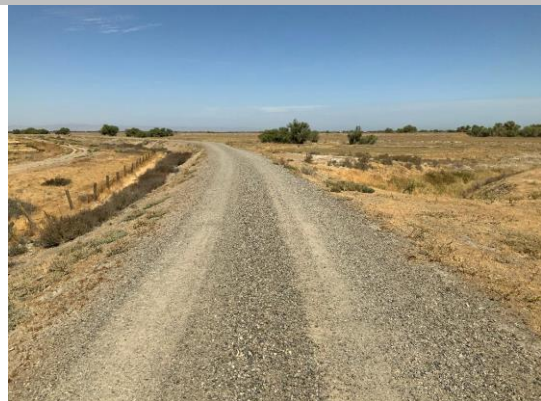
Photo 1 of 3 : UCIP_SP_2022_71098_102952.jpg

FS_ID:71098
DS_ID:19822
EP_NO: N/A
Repair Type: Non-Urgent
Crossing Status: Found
UCIP Comments: 07/27/2021 The record remains Non-Urgent. DWR DMP internal inspection has found pipe integrity issues. LOF of crossing is between 4.1 and 5. Crossing will be monitored until funding becomes available for rehabilitation. There is minor separation of the CMP and concrete headwall on the LS toe. No permit was found authorizing this encroachment. CVFPB will need to review crossing to determine owner. The UCIP inspection was completed with GEI staff, P. Espinoza. (H. Dunn ? GEI) 04/18/2014 Dense vegetation limits the inspector's visibility to identify signs of pipe condition on waterward slope and landward toe (headwall blocked by dense vegetation). Recommend removing vegetation from landward toe. (O. Magana - DWR UCIP)
FIELD_STRUCT_DESC: 24-inch corrugated metal gravity drainage pipe (CMP) through the levee, 10.4 feet below the crown. Flap gate on the waterside (WS) end. Concrete headwall on each end. [Additional Reference(s): DWR Levee Log, 2002, (HLM 3.29). USACE San Joaquin O&M Manual, Unit No. 601, Part No. 1, 1967, Amended in 1978, Revised 20 June 1985, (HLM 3.29). DWR As-Built Specification No. 61-01, Sheet No. 47, 7 March 1961, (HLM 3.29)].

Levee crown.

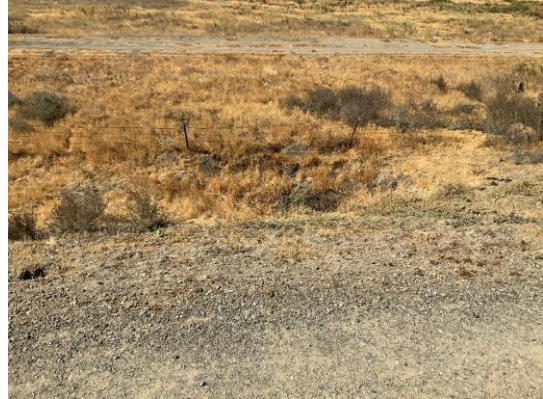
Photo 2 of 3 : UCIP_SP_2022_71098_102953.jpg

LS view: Toe from crown.

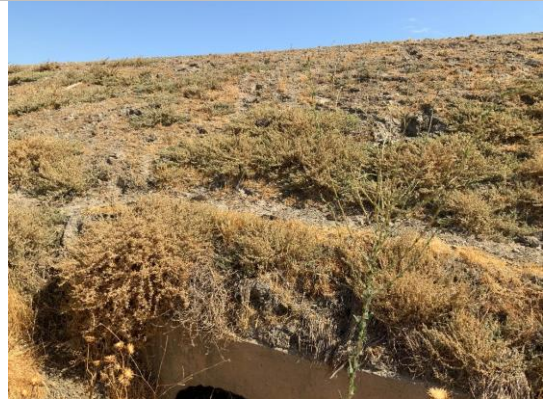
Photo 3 of 3 : UCIP_SP_2022_71098_102954.jpg

LS view: Slope from toe.

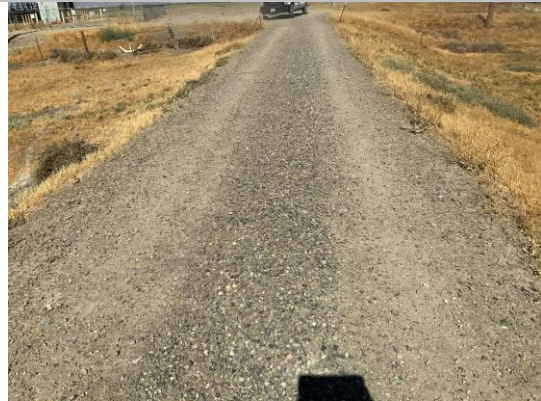
Photo 1 of 3 : UCIP_SP_2022_71101_102976.jpg

Comment Code						
Inspector Comment						
FS_ID:71101 DS_ID:19825 EP_NO: N/A Repair Type: Non-Urgent Crossing Status: Found UCIP Comments: 07/27/2021 The record remains Non-Urgent. DWR DMP internal inspection has found pipe integrity issues. LOF of crossing is between 4.1 and 5. Crossing will be monitored until funding becomes available for rehabilitation. WS riser has broken cover, creating a safety hazard. Limited inspection due to dense tumbleweeds over LS inlet, recommend removal. No permit was found authorizing this encroachment. CVFPB will need to review crossing to determine owner. The UCIP inspection was completed with GEI staff, P. Espinoza. (H. Dunn ? GEI) 04/18/2014 Sediment buildup inside pipe visible from landward side. Excess soil is also present on landward toe partially blocking concrete headwall and inlet. Recommend removing soil from landward toe and clear buildup inside. (O. Magana - DWR UCIP) FIELD_STRUCT_DESC: 36-inch corrugated metal gravity drainage pipe (CMP) through the levee, 6.8 feet below the crown. Slide gate in a 48-inch CMP riser unit on the waterside (WS) slope. Concrete headwall on each end. Pipe connects to a 30-inch steel drainage pipe on the WS. Drainage pipe extends to the pump on the WS on a support platform in the channel. (30-inch drainage pipe and pump authorized under Permit No. 12527, 1979 - Joseph Gallo). [Additional Reference(s): DWR Levee Log, 2002, (HLM 3.54). USACE San Joaquin O&M Manual, Unit No. 601, Part No. 1, 1967, Amended in 1978, Revised 20 June 1985, (HLM 3.54). DWR As-Built Specification No. 61-01, Sheet No. 47, 7 March 1961, (HLM 3.54)]. FS Date: 7/27/2021

Levee crown.

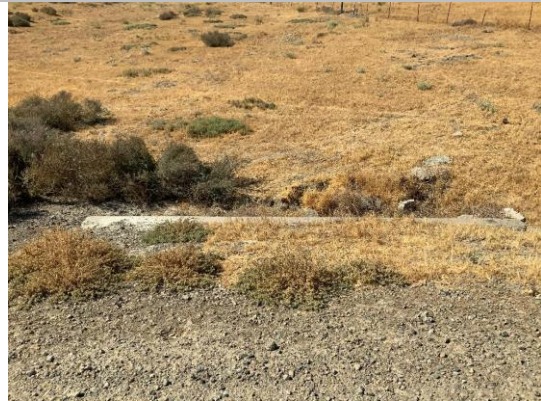
Photo 2 of 3 : UCIP_SP_2022_71101_102972.jpg

LS view: Headwall visible at toe from crown.

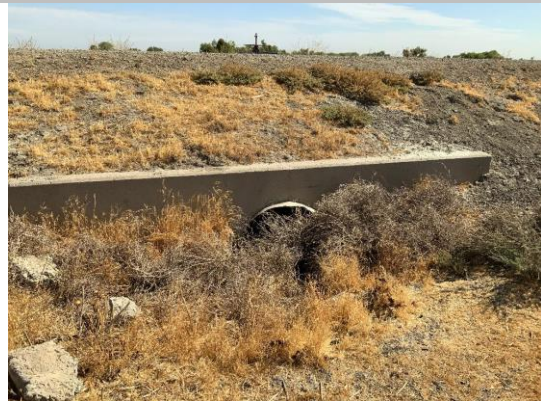
Photo 3 of 3 : UCIP_SP_2022_71101_102973.jpg

LS view: Headwall and slope from toe.

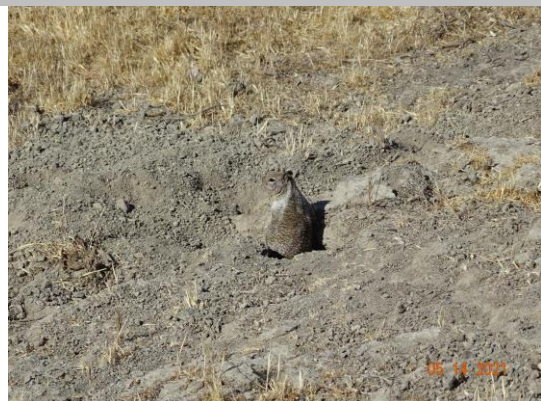
Photo 1 of 1 : SP_2022_NA0010_124_67_20220308_00007.jpg

LM Start	3.49	Rating **	M	Issue No.	67
LM End	3.49	Issue Type +	Ma	Location *	LS
Category	Earthen Levee			GPS Latitude/Longitude	
				Start	End
Item	Animal Control			37.251602 °	37.251602 °
				-120.778118 °	-120.778118 °
DWR ID	DWR_NA0010_06_f_2017_67				
Comment Code					
A1 : Exterminate rodents and backfill and compact or grout burrows.					
Inspector Comment

View of active rodent and burrow on the landside slope. (Spring 2021)

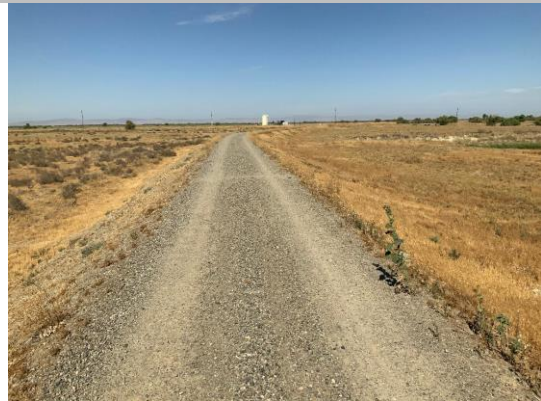
Photo 1 of 3 : UCIP_SP_2022_71102_102981.jpg

Comment Code						
Inspector Comment						
FS_ID:71102 DS_ID:19826 EP_NO: N/A Repair Type: Non-Urgent Crossing Status: Found UCIP Comments: 07/27/2021 The record remains Non-Urgent. DWR DMP internal inspection has found pipe integrity issues. LOF of crossing is between 4.1 and 5. Crossing will be monitored until funding becomes available for rehabilitation. Limited inspection of LS pipe inlet due to vegetation covering it, recommend removal. Exterior liner of WS flapgate is significantly chipping off. No permit was found authorizing this encroachment. CVFPB will need to review crossing to determine owner. The UCIP inspection was completed with GEI staff, P. Espinoza. (H. Dunn ? GEI) 04/18/2014 Sediment buildup inside crossing and is visible from landward side. Recommend clearing sediment buildup inside pipe and check wall integrity to determine condition. (O. Magana - DWR UCIP) FIELD_STRUCT_DESC: 24-inch corrugated metal gravity drainage pipe (CMP) through the levee, 7.0 feet below the crown. Flap gate on the waterside (WS) end. Concrete headwall on each end. [Additional Reference(s): DWR Levee Log, 2002, (HLM 3.78). USACE San Joaquin O&M Manual, Unit No. 601, Part No. 1, 1967, Amended in 1978, Revised 20 June 1985, (HLM 3.77). DWR As-Built Specification No. 61-01, Sheet No. 47, 7 March 1961, (HLM 3.77)]. FS Date: 7/27/2021

Levee crown.

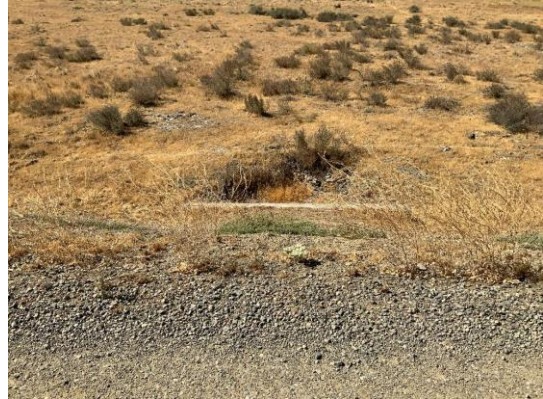
Photo 2 of 3 : UCIP_SP_2022_71102_102982.jpg

LS view: Headwall visible at toe from crown.

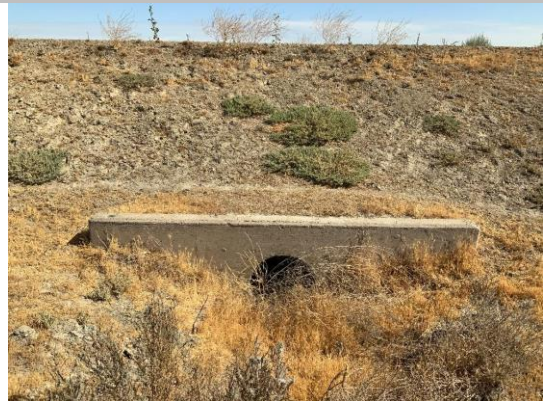
Photo 3 of 3 : UCIP_SP_2022_71102_102983.jpg

LS view: Headwall and slope from toe.

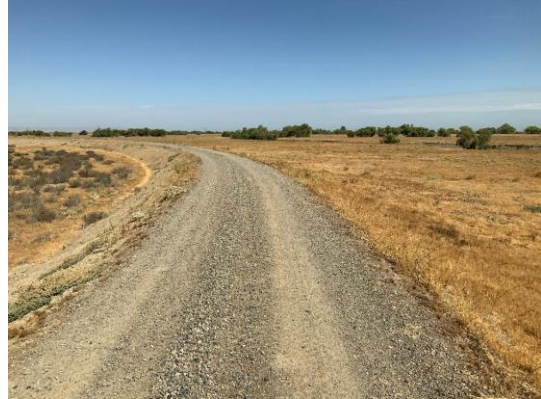
Photo 1 of 3 : UCIP_SP_2022_71103_102994.jpg

Comment Code					
Inspector Comment					
FS_ID:71103 DS_ID:19827 EP_NO: N/A Repair Type: Non-Urgent Crossing Status: Found UCIP Comments: 07/27/2021 The record remains Non-Urgent. DWR DMP internal inspection has found pipe integrity issues. LOF of crossing is between 4.1 and 5. Crossing will be monitored until funding becomes available for rehabilitation. No permit was found authorizing this encroachment. CVFPB will need to review crossing to determine owner. The UCIP inspection was completed with GEI staff, P. Espinoza. (H. Dunn ? GEI) 04/18/2014 Sediment buildup inside crossing and is visible from landward side. Recommend clearing sediment buildup inside pipe and check wall integrity to determine condition. (O. Magana - DWR UCIP) FIELD_STRUCT_DESC: 36-inch corrugated metal gravity drainage pipe (CMP) through the levee, 6.7 feet below the crown. Slide gate in a 48-inch CMP riser unit on the waterside (WS) slope. [Additional Reference(s): DWR Levee Log, 2002, (HLM 3.98). USACE San Joaquin O&M Manual, Unit No. 601, Part No. 1, 1967, Amended in 1978, Revised 20 June 1985, (HLM 3.97). DWR As-Built Specification No. 61-01, Sheet No. 47, 7 March 1961, (HLM 3.97)]. FS Date: 7/27/2021

Levee crown.

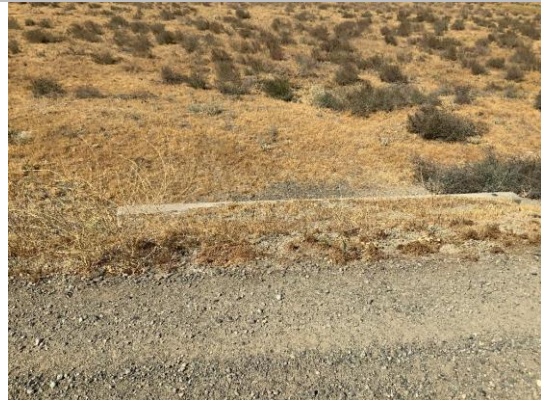
Photo 2 of 3 : UCIP_SP_2022_71103_102995.jpg

LS view: Headwall visible at toe from crown.

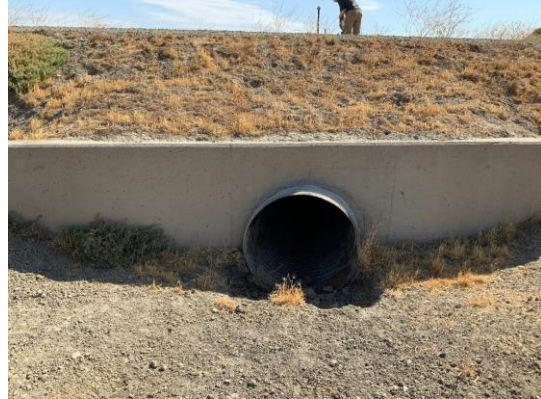
Photo 3 of 3 : UCIP_SP_2022_71103_102996.jpg

LS view: Headwall and slope from toe.

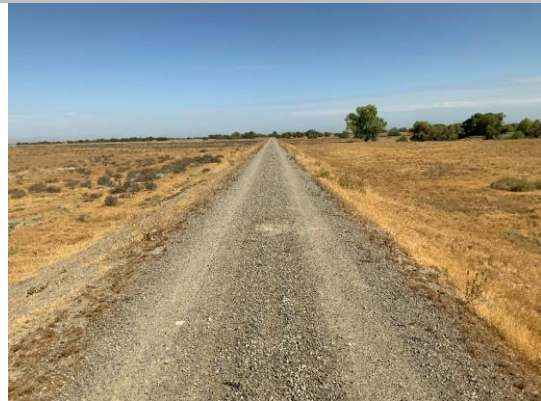
Photo 1 of 3 : UCIP_SP_2022_71104_103005.jpg

FS_ID:71104
DS_ID:19828
EP_NO: N/A
Repair Type: Non-Urgent
Crossing Status: Found
UCIP Comments: 07/27/2021 The record remains Non-Urgent. Limited inspection due to LS pipe inlet being covered by dense tumbleweeds, recommend removal. No permit was found authorizing this encroachment. CVFPB will need to review crossing to determine owner. The UCIP inspection was completed with GEI staff, P. Espinoza. (H. Dunn ? GEI) 04/18/2014 Dense vegetation limits the inspector's visibility to identify signs of pipe condition on landward toe--headwall blocked by dense vegetation. Recommend removing vegetation from landward toe. (O. Magana - DWR UCIP)
FIELD_STRUCT_DESC: 24-inch corrugated metal gravity drainage pipe (CMP) through the levee, 10.8 feet below the crown. Flap gate on the waterside (WS) end. Concrete headwall on each end. [Additional Reference(s): DWR Levee Log, 2002, (HLM 4.17). USACE San Joaquin O&M Manual, Unit No. 601, Part No. 1, 1967, Amended in 1978, Revised 20 June 1985, (HLM 4.17). DWR As-Built Specification No. 61-01, Sheet No. 48, 7 March 1961, (HLM 4.17)].

Levee crown.

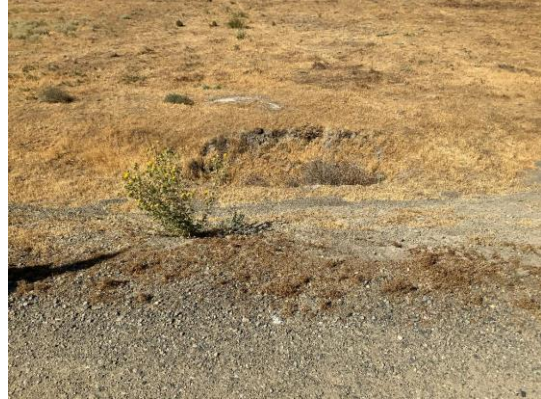
Photo 2 of 3 : UCIP_SP_2022_71104_103006.jpg

LS view: Toe from crown.

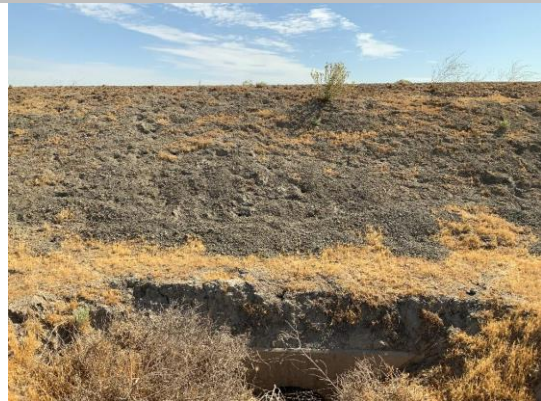
Photo 3 of 3 : UCIP_SP_2022_71104_103007.jpg

LS view: Slope from toe.

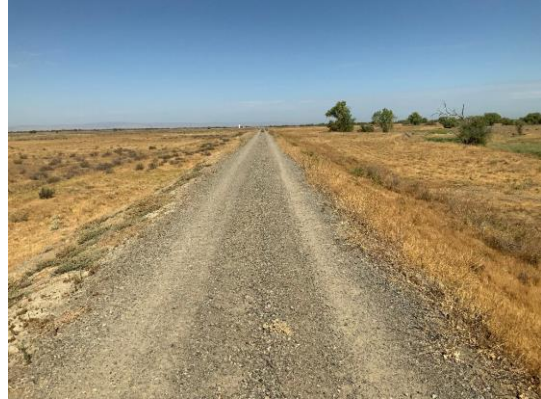
Photo 1 of 3 : UCIP_SP_2022_71105_103019.jpg

Comment Code						
Inspector Comment						
FS_ID:71105 DS_ID:19829 EP_NO: N/A Repair Type: Non-Urgent Crossing Status: Found UCIP Comments: 07/27/2021 The record remains Non-Urgent. DWR DMP internal inspection has found pipe integrity issues. LOF of crossing is between 4.1 and 5. Crossing will be monitored until funding becomes available for rehabilitation. Limited inspection due to LS pipe inlet having some vegetation overgrowth over it, recommend removal. No permit was found authorizing this encroachment. CVFPB will need to review crossing to determine owner. The UCIP inspection was completed with GEI staff, P. Espinoza. (H. Dunn ? GEI) 04/18/2014 Dense vegetation limits the inspector's visibility to identify signs of pipe condition on landward toe--headwall blocked by dense vegetation. Recommend removing vegetation from landward toe. (O. Magana - DWR UCIP) FIELD_STRUCT_DESC: 24-inch corrugated metal gravity drainage pipe (CMP) through the levee, 11.3 feet below the crown. Flap gate on the waterside (WS) end. Concrete headwall on each end. [Additional Reference(s): DWR Levee Log, 2002, (HLM 4.43). USACE San Joaquin O&M Manual, Unit No. 601, Part No. 1, 1967, Amended in 1978, Revised 20 June 1985, (HLM 4.41). DWR As-Built Specification No. 61-01, Sheet No. 48, 7 March 1961, (HLM 4.41)]. FS Date: 7/27/2021

Levee crown.

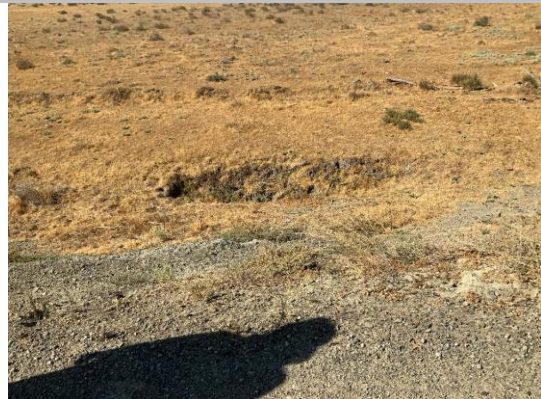
Photo 2 of 3 : UCIP_SP_2022_71105_103020.jpg

LS view: Toe from crown.

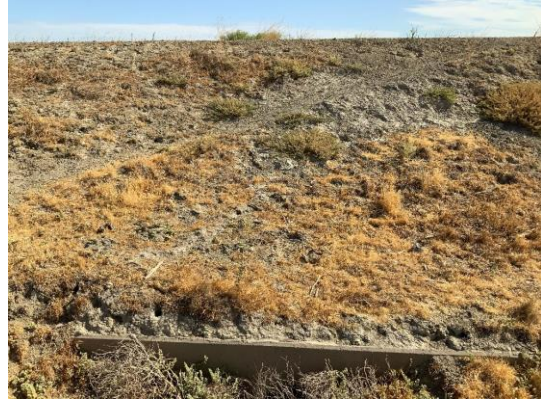
Photo 3 of 3 : UCIP_SP_2022_71105_103021.jpg

LS view: Headwall and slope from toe.

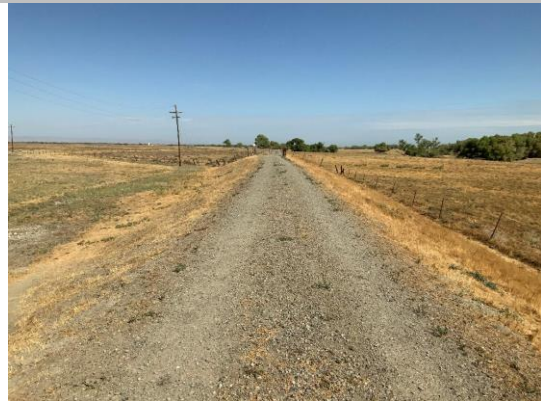
Photo 1 of 3 : UCIP_SP_2022_71106_103030.jpg

FS_ID:71106
DS_ID:19830
EP_NO: N/A
Repair Type: Non-Urgent
Crossing Status: Found
UCIP Comments: 07/27/2021 The record remains Non-Urgent. WS riser has no cover, causing safety hazard. Limited inspection due to LS pipe inlet completely buried within large dirt pile, recommend clearing out. No permit was found authorizing this encroachment. CVFPB will need to review crossing to determine owner. The UCIP inspection was completed with GEI staff, P. Espinoza. (H. Dunn ? GEI) 04/18/2014 Sediment buildup inside crossing visible from landward side. Recommend clearing sediment buildup inside pipe and check wall integrity to determine condition. (O. Magana - DWR UCIP)
FIELD_STRUCT_DESC: 36-inch corrugated metal gravity drainage pipe (CMP) through the levee, 6.9 feet below the crown. Slide gate in a 48-inch CMP riser unit on the waterside (WS) slope. Concrete headwall on the landside (LS) end. Concrete saddle and apron on the WS end. [Additional Reference(s): DWR Levee Log, 2002, (HLM 4.69). USACE San Joaquin O&M Manual, Unit No. 601, Part No. 1, 1967, Amended in 1978, Revised 20 June 1985, (HLM 4.70). DWR As-Built Specification No. 61-01, Sheet No. 48, 7 March 1961, (HLM 4.70)].

Levee crown.

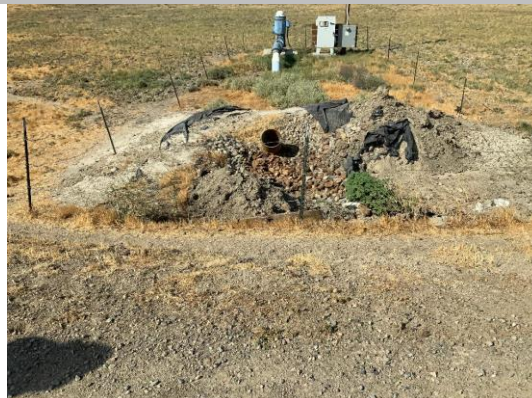
Photo 2 of 3 : UCIP_SP_2022_71106_103031.jpg

LS view: Toe from crown.

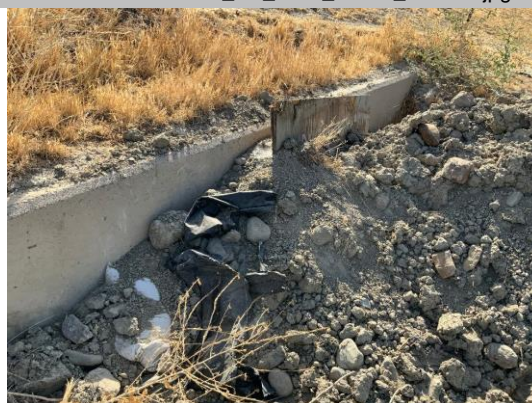
Photo 3 of 3 : UCIP_SP_2022_71106_103032.jpg

LS view: Pile of dirt completely covering pipe inlet at toe.

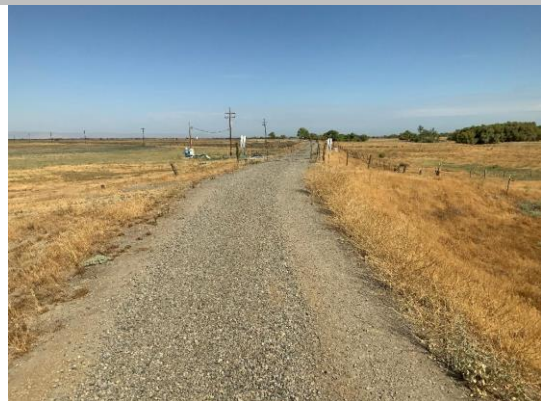
Photo 1 of 3 : UCIP_SP_2022_71107_103037.jpg

Comment Code					
Inspector Comment					
FS_ID:71107 DS_ID:19831 EP_NO: N/A Repair Type: Urgent Crossing Status: Found UCIP Comments: 07/27/2021 The record has been upgraded from Non-Urgent to Urgent. DWR DMP internal inspection has found pipe integrity issues. LOF of crossing is greater than or equal to 5. Crossing will be monitored until funding becomes available to address the issues. Vegetation over LS pipe inlet, recommend removal. No permit was found authorizing this encroachment. CVFPB will need to review crossing to determine owner. The UCIP inspection was completed with GEI staff, P. Espinoza. (H. Dunn ? GEI)04/18/2014 Need to contact owner. Recommend removing tall grass on landward toe to determine condition of crossing from landward side. (O. Magana - DWR UCIP) FIELD_STRUCT_DESC: 24-inch corrugated metal gravity drainage pipe (CMP) through the levee, 11.8 feet below the crown. Flap gate on the waterside (WS) end. Concrete headwall on each end. [Additional Reference(s): DWR Levee Log, 2002, (HLM 4.75). USACE San Joaquin O&M Manual, Unit No. 601, Part No. 1, 1967, Amended in 1978, Revised 20 June 1985, (HLM 4.75). DWR As-Built Specification No. 61-01, Sheet No. 48, 7 March 1961, (HLM 4.75)]. FS Date: 7/27/2021

Levee crown.

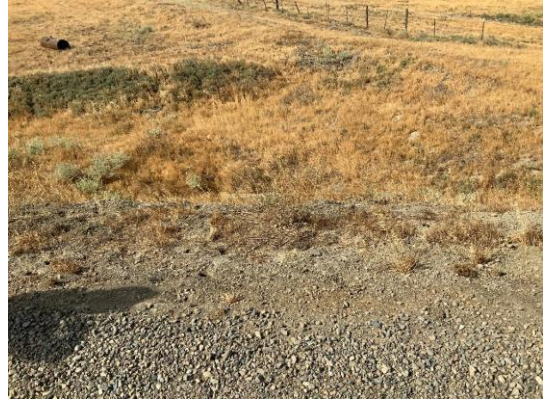
Photo 2 of 3 : UCIP_SP_2022_71107_103038.jpg

LS view: Toe from crown.

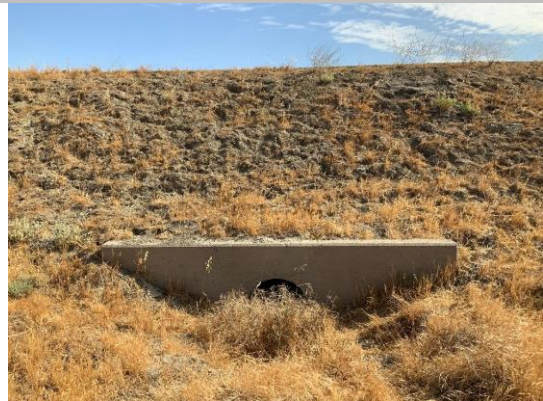
Photo 3 of 3 : UCIP_SP_2022_71107_103039.jpg

LS view: Headwall and slope from toe.

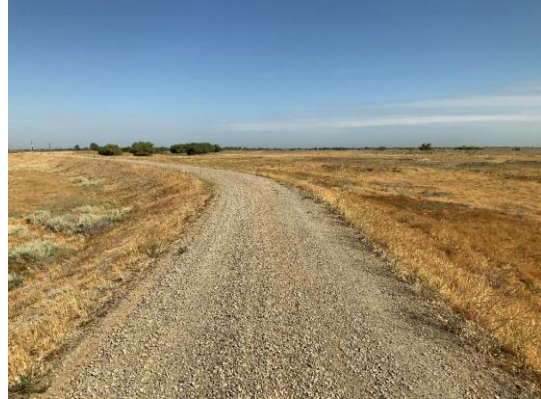
Photo 1 of 3 : UCIP_SP_2022_71108_103046.jpg

FS_ID:71108
DS_ID:19862
EP_NO: N/A
Repair Type: Non-Urgent
Crossing Status: Found
UCIP Comments: 07/27/2021 The record remains Non-Urgent. DWR DMP internal inspection has found pipe integrity issues. LOF of crossing is between 4.1 and 5. Crossing will be monitored until funding becomes available for rehabilitation. Limited inspection due to dense vegetation over LS pipe inlet, recommend removal. No permit was found authorizing this encroachment. CVFPB will need to review crossing to determine owner. The UCIP inspection was completed with GEI staff, P. Espinoza. (H. Dunn ? GEI) 04/18/2014 Dense vegetation limits the inspector's visibility to identify signs of pipe failure (leaks) along the waterward slope. Recommend removing vegetation along waterward slope to conduct proper inspection of structure. Also recommend removing dense vegetation blocking landward headwall. (O. Magana - DWR UCIP)
FIELD_STRUCT_DESC: 24-inch corrugated metal gravity drainage pipe (CMP) through the levee, 10.8 feet below the crown. Flap gate on the waterside (WS) end. Concrete headwall on each end. [Additional Reference(s): DWR Levee Log, 2002, (HLM 4.95). USACE San Joaquin O&M Manual, Unit No. 601, Part No. 1, 1967, Amended in 1978, Revised 20 June 1985, (HLM 4.94). DWR As-Built Specification No. 61-01, Sheet No. 48, 7 March 1961, (HLM 4.94)].

Levee crown.

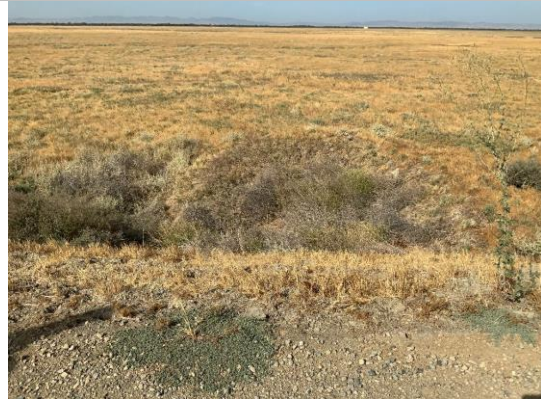
Photo 2 of 3 : UCIP_SP_2022_71108_103047.jpg

LS view: Toe from crown.

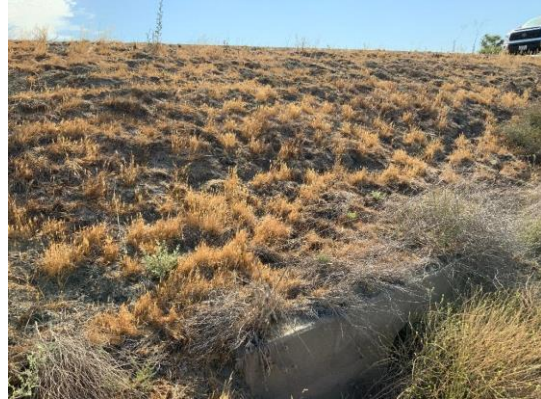
Photo 3 of 3 : UCIP_SP_2022_71108_103048.jpg

LS view: Headwall and slope from toe.
