**Flood Control Project Maintenance
Levee Inspections**

Maintenance Issue Types Only, Levee Inspection Report By Mile - Spring 2022

Lower San Joaquin Levee District

Waterway	Bank	Unit Miles	Inspection Start/End	Inspector
Unit No. 01 San Joaquin River	Right	22.52	04/05/2022 04/05/2022	Corey Fujitani

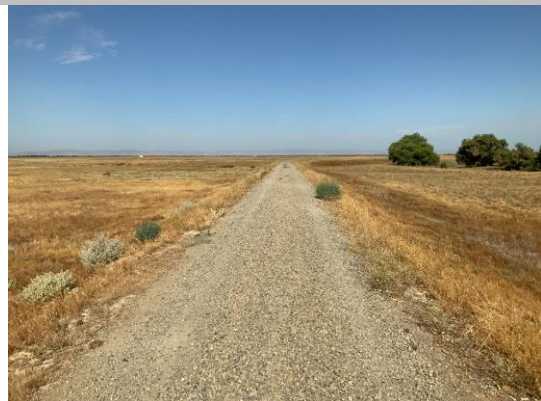
Photo 1 of 3 : UCIP_SP_2022_71109_103067.jpg

FS_ID:71109
 DS_ID:19863
 EP_NO: N/A
 Repair Type: Non-Urgent
 Crossing Status: Found
 UCIP Comments: 07/27/2021 The record remains Non-Urgent. DWR DMP internal inspection has found pipe integrity issues. LOF of crossing is greater than or equal to 4.1 and less than 5. Crossing will be monitored until funding becomes available for rehabilitation. No permit was found authorizing this encroachment. CVFPB will need to review crossing to determine owner. The UCIP inspection was completed with GEI staff, P. Espinoza. (H. Dunn ? GEI) 04/18/2014 Clear vegetation from waterward slope and landward headwall. (O. Magana - DWR UCIP) FIELD_STRUCT_DESC: 24-inch corrugated metal gravity drainage pipe (CMP) through the levee, 10.9 feet below the crown. Flap gate on the waterside (WS) end. Concrete headwall on each end. [Additional Reference(s): DWR Levee Log, 2002, (HLM 5.35). USACE San Joaquin O&M Manual, Unit No. 601, Part No. 1, 1967, Amended in 1978, Revised 20 June 1985, (HLM 5.34). DWR As-Built Specification No. 61-01, Sheet No. 48, 7 March 1961, (HLM 5.34)].

Levee crown.

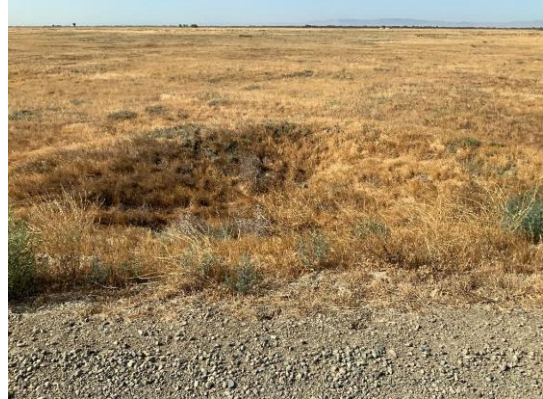
Photo 2 of 3 : UCIP_SP_2022_71109_103068.jpg

LS view: Toe from crown.

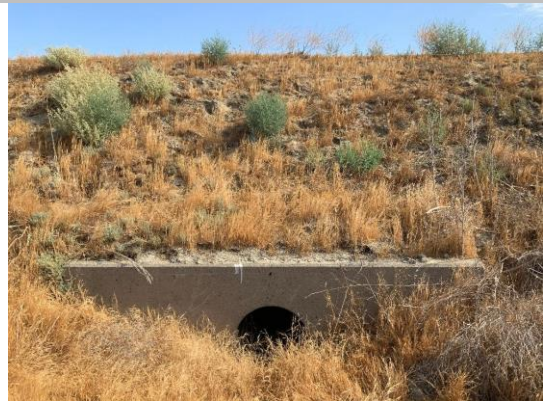
Photo 3 of 3 : UCIP_SP_2022_71109_103069.jpg

LS view: Headwall and slope from toe.

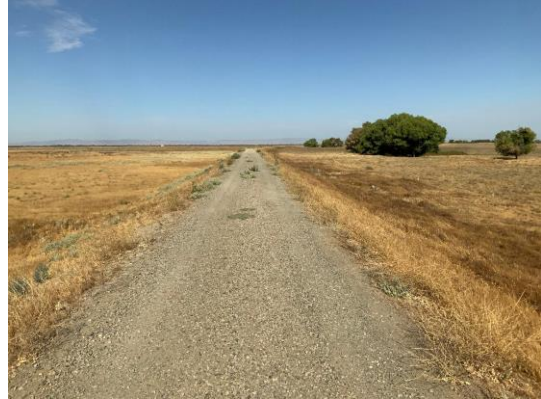
Photo 1 of 3 : UCIP_SP_2022_71110_103076.jpg

Comment Code						
Inspector Comment						
FS_ID:71110 DS_ID:19864 EP_NO: N/A Repair Type: Non-Urgent Crossing Status: Found UCIP Comments: 07/27/2021 The record remains Non-Urgent. DWR DMP internal inspection has not found pipe integrity issues. LOF of crossing is less or equal to 4.0. Recommend next video inspection in 5 years. Limited inspection due to vegetation over LS pipe inlet, recommend removal. No permit was found authorizing this encroachment. CVFPB will need to review crossing to determine owner. The UCIP inspection was completed with GEI staff, P. Espinoza. (H. Dunn ? GEI) 04/18/2014 Dense vegetation limits the inspector's visibility to identify signs of pipe failure (leaks) along the waterward slope. Recommend removing vegetation along pipe alignment to conduct proper inspection of structure. Also recommend removing excess vegetation at landward headwall. (O. Magana - DWR UCIP) FIELD_STRUCT_DESC: 24-inch corrugated metal gravity drainage pipe (CMP) through the levee, 11.0 feet below the crown. Flap gate on the waterside (WS) end. Concrete headwall on each end. [Additional Reference(s): DWR Levee Log, 2002, (HLM 5.63). USACE San Joaquin O&M Manual, Unit No. 601, Part No. 1, 1967, Amended in 1978, Revised 20 June 1985, (HLM 5.63). DWR As-Built Specification No. 61-01, Sheet No. 49, 7 March 1961, (HLM 5.63)]. FS Date: 7/27/2021

Levee crown.

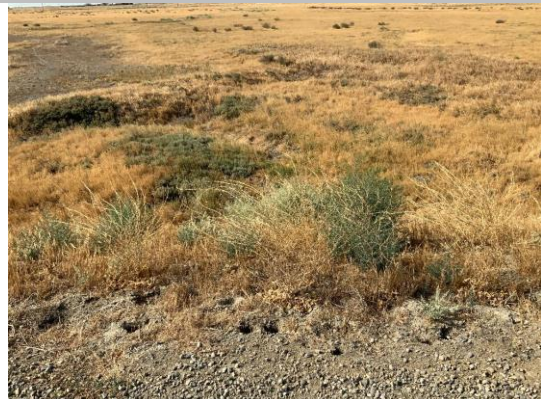
Photo 2 of 3 : UCIP_SP_2022_71110_103077.jpg

LS view: Toe from crown.

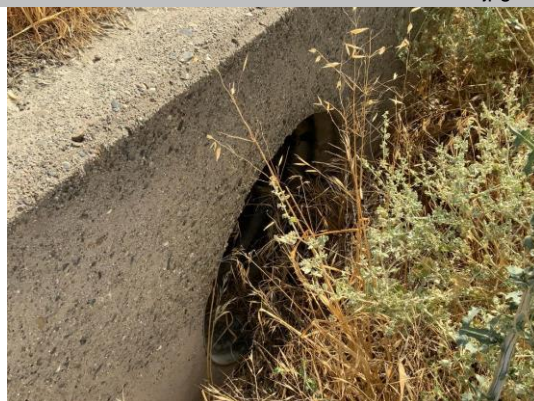
Photo 3 of 3 : UCIP_SP_2022_71110_103078.jpg

LS view: Closeup of pipe inlet at toe with vegetation growth.

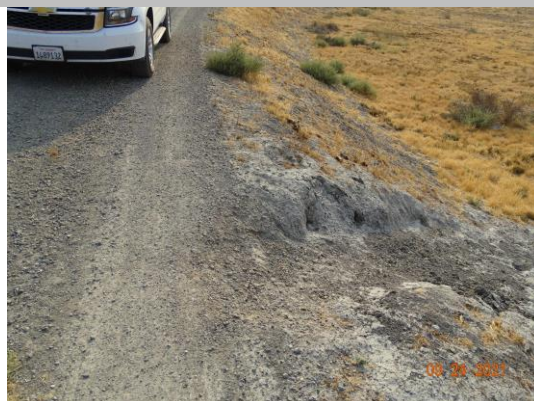
Photo 1 of 1 : SP_2022_NA0010_124_66_20220308_00006.jpg

LM Start	5.77	Rating **	U	Issue No.	66
LM End	5.77	Issue Type +	Ma	Location *	LS
Category	Earthen Levee			GPS Latitude/Longitude	
				Start	End
Item	Erosion / Livestock			37.238354 °	37.238354 °
				-120.742480 °	-120.742480 °
DWR ID	DWR_NA0010_06_f_2017_66				
Comment Code					
E4 : Repair the levee slope damaged by livestock and prevent large animal access.					
Inspector Comment					
There is damage to the landside slope and shoulder from livestock.

View of damage to landside slope from livestock traffic looking downstream. (Fall 2021)

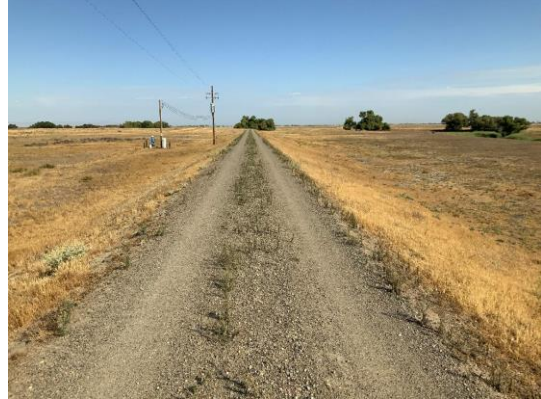
Photo 1 of 3 : UCIP_SP_2022_71111_103092.jpg

Comment Code					
Inspector Comment					
FS_ID:71111 DS_ID:19865 EP_NO: N/A Repair Type: Non-Urgent Crossing Status: Found UCIP Comments: 07/27/2021 The record has been upgraded from No Action Needed to Non-Urgent. No permit was found authorizing this encroachment. CVFPB will need to review crossing to determine owner. Crossing appears to be in good condition. Separate 10 inch plastic pipe inlet and flowmeter off the LS toe across this Crossing's inlet. The UCIP inspection was completed with GEI staff, P. Espinoza. (H. Dunn ? GEI) 7/19/2016 Site has been repaired on WS and LS (see photos below). (O. Magana - DWR UCIP)5/26/2016 Erosion is undermining the WS headwall of drainage structure (photos of WS headwall provided by DWR Inspector R. Willoughby). Potential pipe failure at the outlet just behind headwall, recommend completing internal wall integrity of pipe length through levee to determine extent of damage to pipe. (O. Magana - DWR UCIP)4/18/2014 Need to contact owner. Sediment buildup in pipe visible on landside--recommend clearing. (O. Magana - DWR UCIP) FIELD_STRUCT_DESC: 24-inch corrugated metal gravity drainage pipe (CMP) through the levee, 9.0 feet below the crown. Flap gate on the waterside (WS) end. Concrete headwall on each end. [Additional Reference(s): DWR Levee Log, 2002, (HLM 6.06). USACE San Joaquin O&M Manual, Unit No. 601, Part No. 1, 1967, Amended in 1978, Revised 20 June 1985, (HLM 6.06). DWR As-Built Specification No. 61-01, Sheet No. 49, 7 March 1961, (HLM 6.06)]. FS Date: 7/27/2021

Levee crown.

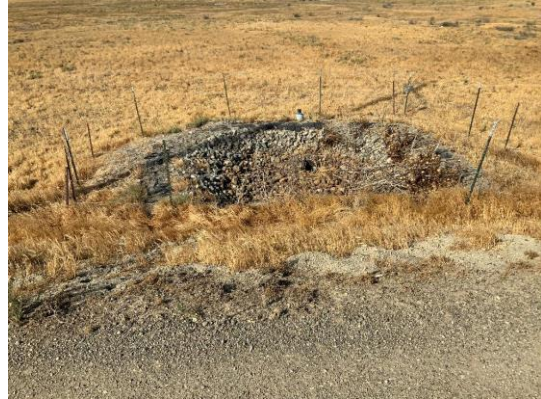
Photo 2 of 3 : UCIP_SP_2022_71111_103093.jpg

LS view: Toe from crown.

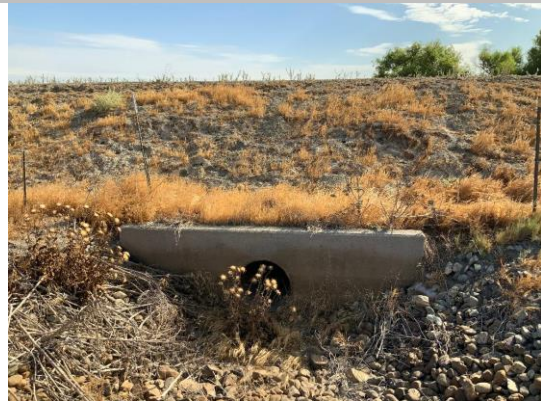
Photo 3 of 3 : UCIP_SP_2022_71111_103094.jpg

LS toe: Headwall and slope from toe.

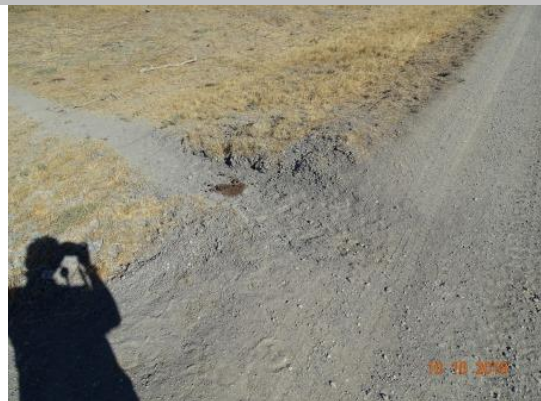
Photo 1 of 1 : SP_2022_NA0010_124_85_20220308_00020.jpg

LM Start	6.09	Rating **	M	Issue No.	85
LM End	6.09	Issue Type +	Ma	Location *	WS
Category	Earthen Levee			GPS Latitude/Longitude	
				Start	End
Item	Erosion / Livestock			37.235572 °	37.235572 °
				-120.738002 °	-120.738002 °
DWR ID	DWR_NA0010_06_f_2018_85				
Comment Code					
E4 : Repair the levee slope damaged by livestock and prevent large animal access.					
Inspector Comment					
Livestock damage to slope and shoulder of levee.

View of livestock damage on waterside slope. (Fall 2018)

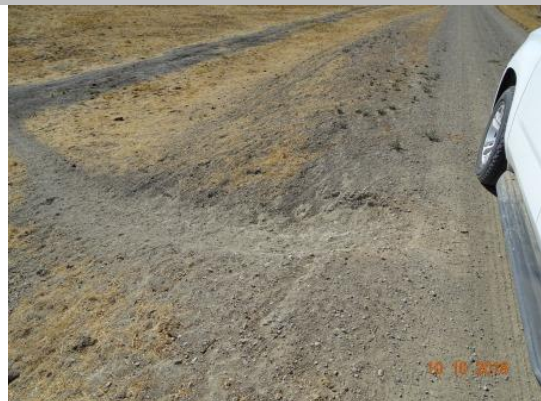
Photo 1 of 1 : SP_2022_NA0010_124_84_20220308_00019.jpg

LM Start	6.10	Rating **	M	Issue No.	84
LM End	6.10	Issue Type +	Ma	Location *	LS
Category	Earthen Levee			GPS Latitude/Longitude	
				Start	End
Item	Erosion / Livestock			37.235570 °	37.235570 °
				-120.737998 °	-120.737998 °
DWR ID	DWR_NA0010_06_f_2018_84				
Comment Code					
E4 : Repair the levee slope damaged by livestock and prevent large animal access.					
Inspector Comment					
Damage to slope and crown from livestock.

Erosion to slope and into crown from livestock. (Fall 2018)

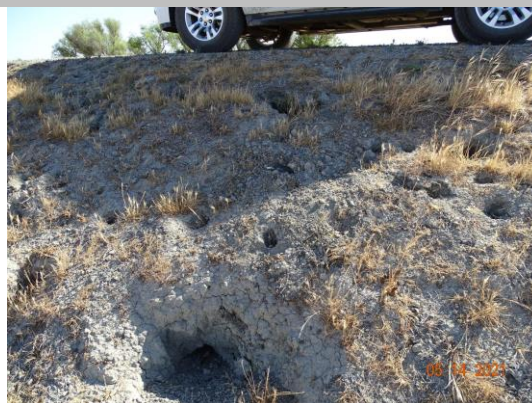
Photo 1 of 1 : SP_2022_NA0010_124_90_20220308_00024.jpg

LM Start	6.63	Rating **	M	Issue No.	90
LM End	6.63	Issue Type +	Ma	Location *	LS
Category	Earthen Levee			GPS Latitude/Longitude	
				Start	End
Item	Animal Control			37.231384 °	37.231384 °
				-120.730297 °	-120.730297 °
DWR ID	DWR_NA0010_06_s _ 2021_90				
Comment Code					
A3 : No rodents visible, but rodent burrows visible; need to backfill and compact or grout burrows.					
Inspector Comment

Looking at multiple rodent holes in the landside slope. (Spring 2021)

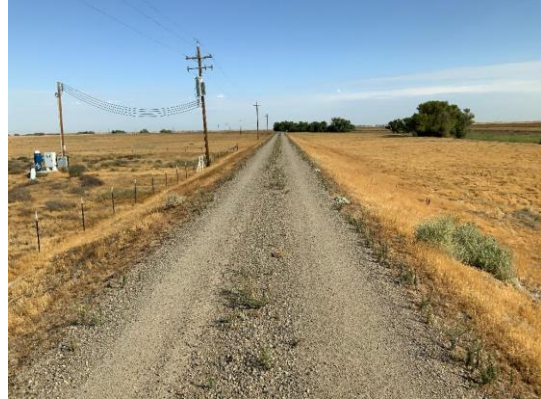
Photo 1 of 3 : UCIP_SP_2022_71112_103109.jpg

Comment Code						
Inspector Comment						
FS_ID:71112 DS_ID:19866 EP_NO: N/A Repair Type: Non-Urgent Crossing Status: Found UCIP Comments: 07/27/2021 The record has been upgraded from No Action Needed to Non-Urgent. Crossing appears to be in good condition. No permit was found authorizing this encroachment. CVFPB will need to review crossing to determine owner. The UCIP inspection was completed with GEI staff, P. Espinoza. (H. Dunn ? GEI) FIELD_STRUCT_DESC: 24-inch corrugated metal gravity drainage pipe (CMP) through the levee, 7.0 feet below the crown. Slide gate in a 36-inch CMP riser unit on the waterside (WS) slope. Concrete headwall on the landside (LS) end. Concrete saddle and apron on the WS end. [Additional Reference(s): DWR Levee Log, 2002, (HLM 6.78). USACE San Joaquin O&M Manual, Unit No. 601, Part No. 1, 1967, Amended in 1978, Revised 20 June 1985, (HLM 6.79). DWR As-Built Specification No. 61-01, Sheet No. 50, 7 March 1961, (HLM 6.79)]. FS Date: 7/27/2021

Levee crown.

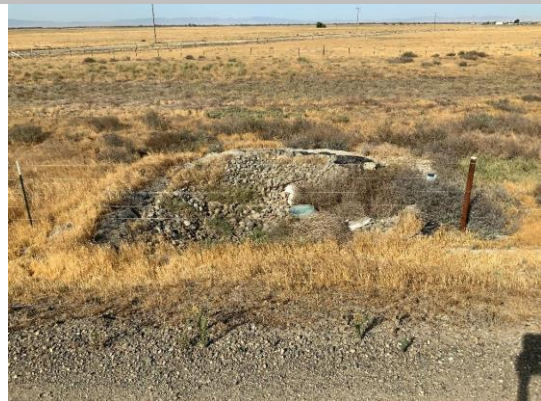
Photo 2 of 3 : UCIP_SP_2022_71112_103106.jpg

LS view: Toe from crown.

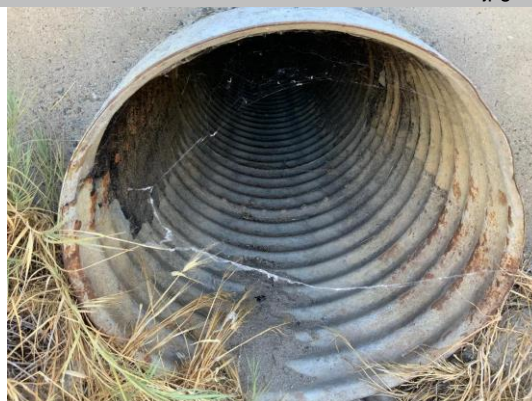
Photo 3 of 3 : UCIP_SP_2022_71112_103107.jpg

LS view: Closeup of pipe inlet at toe.

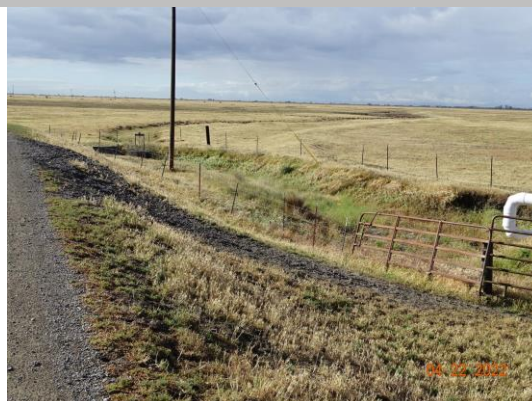
Photo 1 of 1 : SP_2022_NA0010_124_143_20220425_00232.jpg

LM Start	6.88	Rating **	M	Issue No.	143
LM End	6.88	Issue Type +	Ma	Location *	LS
Category	Earthen Levee			GPS Latitude/Longitude	
				Start	End
Item	Erosion / Livestock			37.228370 °	37.228370 °
				-120.728004 °	-120.728004 °
DWR ID	DWR_NA0010_06_s_2022_143				
Comment Code					
E4 : Repair the levee slope damaged by livestock and prevent large animal access.					
Inspector Comment

Levee damage on the landside slope from livestock activity. (Spring 2022)

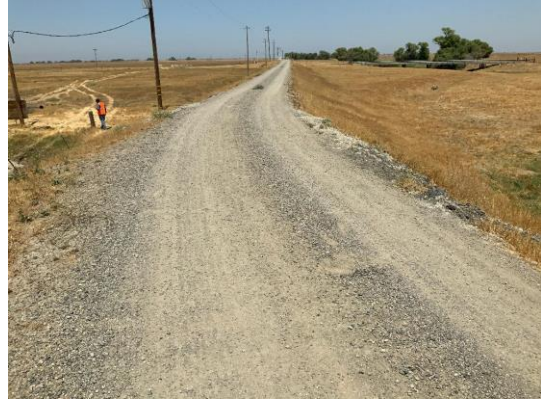
Photo 1 of 3 : UCIP_SP_2022_71113_101625.jpg

Comment Code						
Inspector Comment						
FS_ID:71113 DS_ID:19867 EP_NO: N/A Repair Type: Non-Urgent Crossing Status: Found UCIP Comments: 07/13/2021 The record has been upgraded from No Action Needed to Non-Urgent. The cover on the WS riser is broken, causing a safety concern. There is another riser, pump, and pipe out closer to the channel on the WS but is not within 15 feet of the toe. No permit was found authorizing this encroachment. CVFPB will need to review crossing to determine owner. The UCIP inspection was completed with GEI staff, P. Espinoza. (H. Dunn ? GEI) FIELD_STRUCT_DESC: 36-inch corrugated metal gravity drainage pipe (CMP) through the levee, 10.7 feet below the crown. Slide gate in a 48-inch CMP riser unit on the waterside (WS) slope. Concrete headwall on the landside (LS) end. Concrete U-shaped headwall on the WS end. [Additional Reference(s): DWR Levee Log, 2002, (HLM 6.97). USACE San Joaquin O&M Manual, Unit No. 601, Part No. 1, 1967, Amended in 1978, Revised 20 June 1985, (HLM 6.97). DWR As-Built Specification No. 61-01, Sheet No. 50, 7 March 1961, (HLM 6.97)]. FS Date: 7/13/2021

Levee crown.

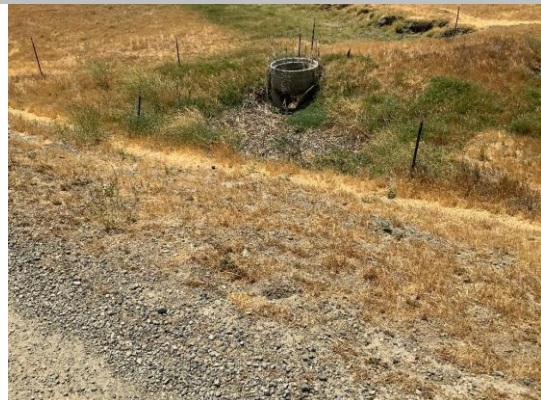
Photo 2 of 3 : UCIP_SP_2022_71113_101628.jpg

LS view: Toe from crown.

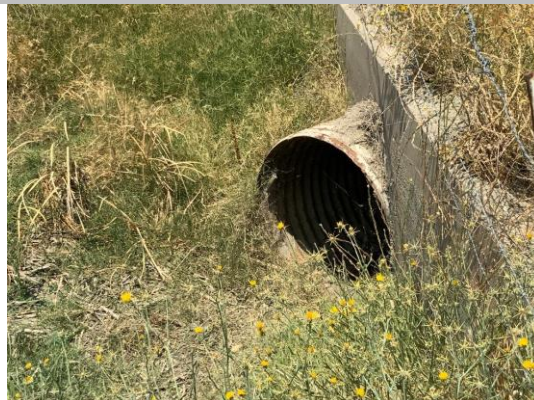
Photo 3 of 3 : UCIP_SP_2022_71113_101629.jpg

LS view: Closeup of pipe inlet at toe.

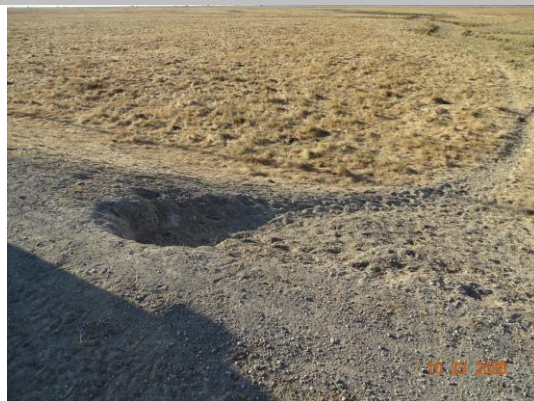
Photo 1 of 1 : SP_2022_NA0010_124_79_20220308_00015.jpg

LM Start	6.92	Rating **	M	Issue No.	79
LM End	6.92	Issue Type +	Ma	Location *	LS
Category	Earthen Levee			GPS Latitude/Longitude	
				Start	End
Item	Erosion / Livestock			37.228054 °	37.228054 °
				-120.727428 °	-120.727428 °
DWR ID	DWR_NA0010_06_f_2018_79				
Comment Code					
E4 : Repair the levee slope damaged by livestock and prevent large animal access.					
Inspector Comment					
Slope damage has been repaired with loose soil. Monitor for settlement.

View down the landside slope of damage from livestock. (Fall 2020)

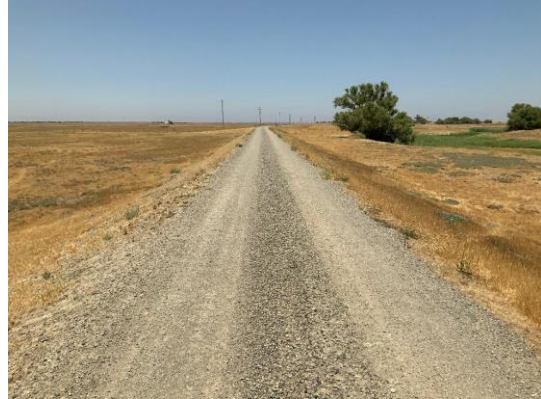
Photo 1 of 3 : UCIP_SP_2022_71114_101634.jpg

Comment Code						
Inspector Comment						
FS_ID:71114 DS_ID:19868 EP_NO: N/A Repair Type: Non-Urgent Crossing Status: Found UCIP Comments: 07/13/2021 Record is still Non-Urgent. DWR DMP internal inspection has found pipe integrity issues. LOF of crossing is between 4.1 and 5. Crossing will be monitored until funding becomes available for rehabilitation. No permit was found authorizing this encroachment. CVFPB will need to review crossing to determine owner. The UCIP inspection was completed with GEI staff, P. Espinoza. (H. Dunn ? GEI) 04/18/2014 Need to contact owner. Clear animal from waterward side. Some sediment buildup in pipe visible landward side--recommend clearing. (O. Magana - DWR UCIP) FIELD_STRUCT_DESC: 24-inch corrugated metal gravity drainage pipe (CMP) through the levee, 10.6 feet below the crown. Flap gate on the waterside (WS) end. Concrete headwall on each end. [Additional Reference(s): DWR Levee Log, 2002, (HLM 7.29). USACE San Joaquin O&M Manual, Unit No. 601, Part No. 1, 1967, Amended in 1978, Revised 20 June 1985, (HLM 7.29). DWR As-Built Specification No. 61-01, Sheet No. 50, 7 March 1961, (HLM 7.29)]. FS Date: 7/13/2021

Levee crown.

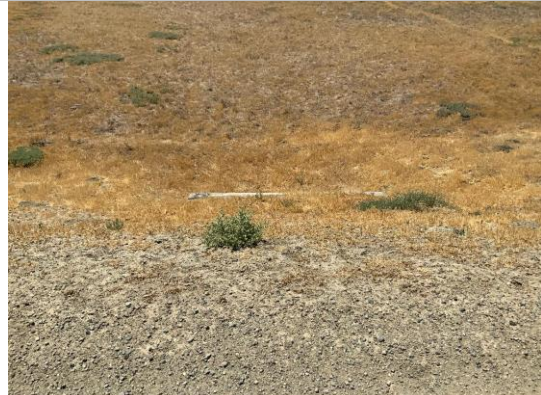
Photo 2 of 3 : UCIP_SP_2022_71114_101638.jpg

LS view: Headwall visible at toe from crown.

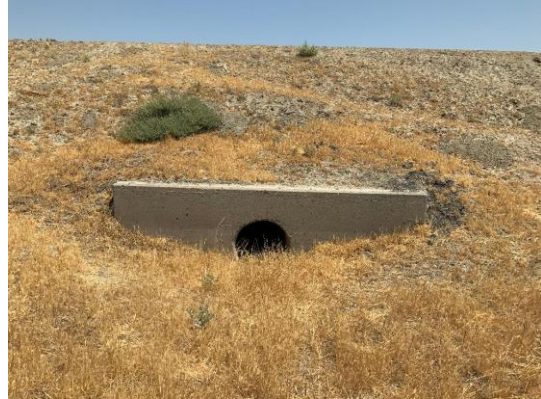
Photo 3 of 3 : UCIP_SP_2022_71114_101639.jpg

LS view: Slope and headwall at toe.

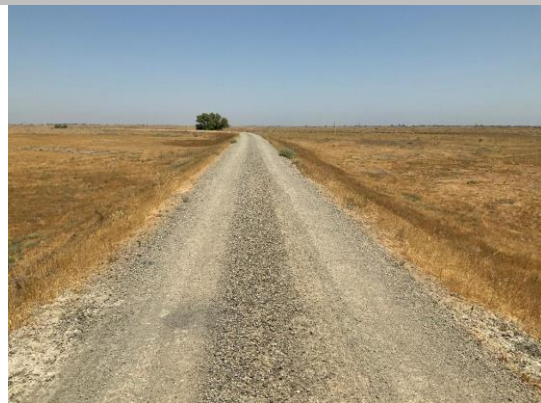
Photo 1 of 3 : UCIP_SP_2022_71115_101643.jpg

FS_ID:71115
DS_ID:19869
EP_NO: N/A
Repair Type: Non-Urgent
Crossing Status: Found
UCIP Comments: 07/13/2021 Record remains Non-Urgent. DWR DMP internal inspection has found pipe integrity issues. LOF of crossing is greater than or equal to 4.1 and less than 5. Crossing will be monitored until funding becomes available for rehabilitation. No longer sediment buildup as mentioned in previous inspection. No permit was found authorizing this encroachment. CVFPB will need to review crossing to determine owner. The UCIP inspection was completed with GEI staff, P. Espinoza. (H. Dunn ? GEI) 04/18/2014 Some sediment buildup in pipe visible on landward side--recommend clearing. (O. Magana - DWR UCIP)
FIELD_STRUCT_DESC: 24-inch corrugated metal gravity drainage pipe (CMP) through the levee, 11.8 feet below the crown. Flap gate on the waterside (WS) end. Concrete headwall on each end. Skewed crossing. [Additional Reference(s): DWR Levee Log, 2002, (HLM 7.74). USACE San Joaquin O&M Manual, Unit No. 601, Part No. 1, 1967, Amended in 1978, Revised 20 June 1985, (HLM 7.74). DWR As-Built Specification No. 61-01, Sheet No. 50, 7 March 1961, (HLM 7.74)].

Levee crown.

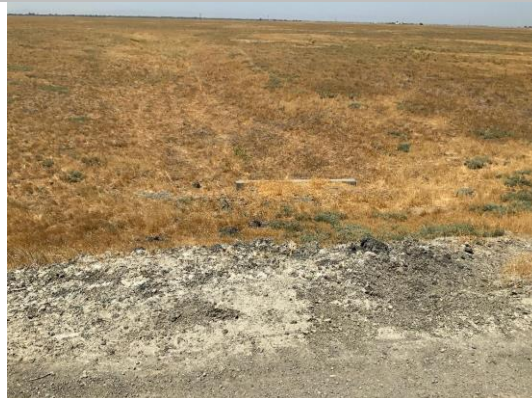
Photo 2 of 3 : UCIP_SP_2022_71115_101644.jpg

LS view: Headwall visible at toe from crown.

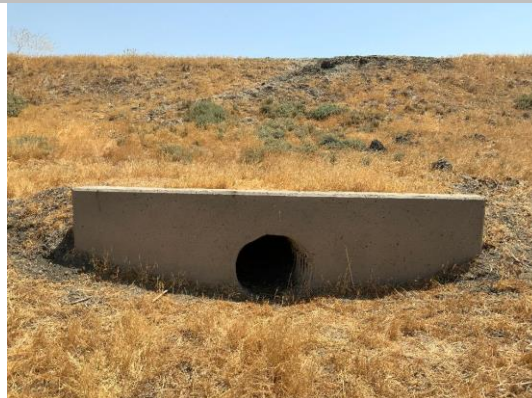
Photo 3 of 3 : UCIP_SP_2022_71115_101645.jpg

LS view: Slope and headwall at toe.

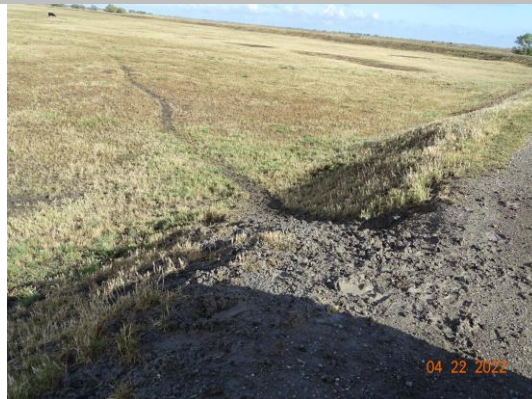
Photo 1 of 1 : SP_2022_NA0010_124_74_20220425_00233.jpg

LM Start	7.66	Rating **	M	Issue No.	74
LM End	7.66	Issue Type +	Ma	Location *	LS
Category	Earthen Levee			GPS Latitude/Longitude	
				Start	End
Item	Erosion / Livestock			37.222689 °	37.222689 °
				-120.716400 °	-120.716400 °
DWR ID	DWR_NA0010_06_f_2018_74				
Comment Code					
E4 : Repair the levee slope damaged by livestock and prevent large animal access.					
Inspector Comment					
Damage to levee slope from livestock access.

Slope damage from livestock. (Spring 2022)

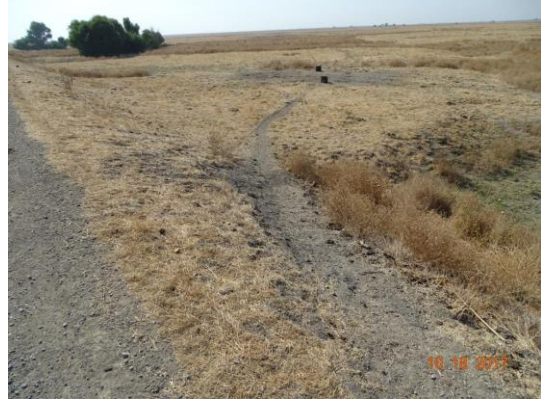
Photo 1 of 1 : SP_2022_NA0010_124_65_20220308_00005.jpg

LM Start	8.08	Rating **	A/W	Issue No.	65
LM End	8.08	Issue Type +	Ma	Location *	LS
Category	Earthen Levee			GPS Latitude/Longitude	
				Start	End
Item	Erosion / Livestock			37.217199 °	37.217199 °
				-120.713374 °	-120.713374 °
DWR ID	DWR_NA0010_06_f_2017_65				
Comment Code					
E4 : Repair the levee slope damaged by livestock and prevent large animal access.					
Inspector Comment					
Livestock damage to levee slope.

Looking southwest at the landside slope.

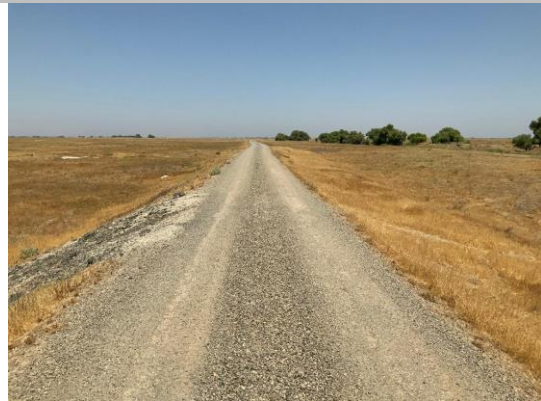
Photo 1 of 3 : UCIP_SP_2022_71116_102248.jpg

Comment Code					
Inspector Comment					
FS_ID:71116 DS_ID:19870 EP_NO: N/A Repair Type: Non-Urgent Crossing Status: Found UCIP Comments: 07/13/2021 Record remains Non-Urgent. DWR DMP internal inspection has found pipe integrity issues. LOF of crossing is greater than or equal to 4.1 and less than 5. Crossing will be monitored until funding becomes available for rehabilitation. Some vegetation buildup over LS pipe inlet and WS flapgate, recommend removal of vegetation on both ends. No permit was found authorizing this encroachment. CVFPB will need to review crossing to determine owner. The UCIP inspection was completed with GEI staff, P. Espinoza. (H. Dunn ? GEI) 04/18/2014 Sediment buildup in pipe--recommend contacting owner to clear sediment. (O. Magana - DWR UCIP) FIELD_STRUCT_DESC: 24-inch corrugated metal gravity drainage pipe (CMP) through the levee, 16.5 feet below the crown. Flap gate on the waterside (WS) end. Concrete headwall on each end. [Additional Reference(s): DWR Levee Log, 2002, (HLM 8.22). USACE San Joaquin O&M Manual, Unit No. 601, Part No. 1, 1967, Amended in 1978, Revised 20 June 1985, (HLM 8.21). DWR As-Built Specification No. 61-01, Sheet No. 51, 7 March 1961, (HLM 8.21)]. FS Date: 7/13/2021

Levee crown.

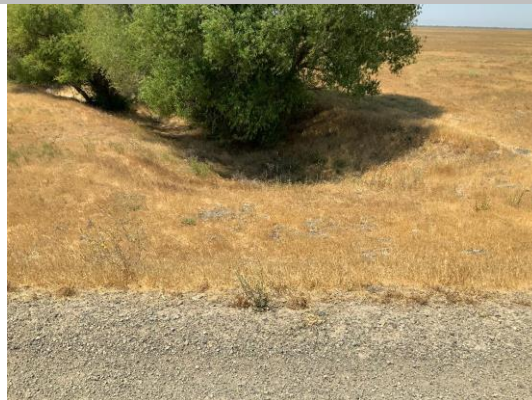
Photo 2 of 3 : UCIP_SP_2022_71116_102249.jpg

LS view: Toe from crown.

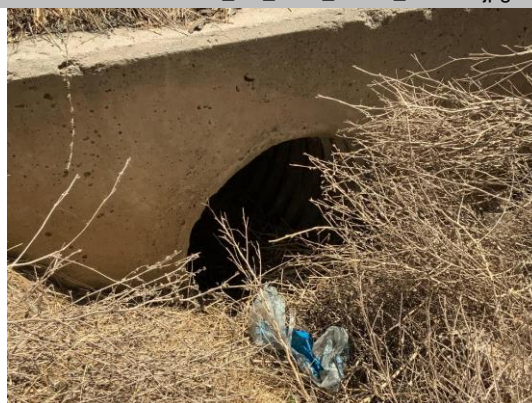
Photo 3 of 3 : UCIP_SP_2022_71116_102250.jpg

LS view: Closeup of pipe inlet at toe. Some vegetation blocking.

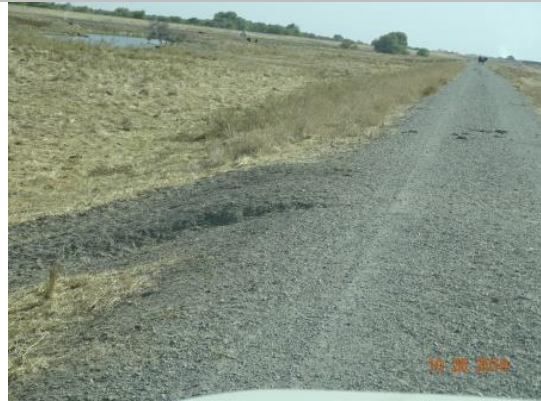
Photo 1 of 1 : SP_2022_NA0010_124_89_20220308_00023.jpg

LM Start	8.32	Rating **	A/W	Issue No.	89
LM End	8.32	Issue Type +	Ma	Location *	WS
Category	Earthen Levee			GPS Latitude/Longitude	
				Start	End
Item	Erosion / Livestock			37.214273 °	37.214273 °
				-120.711100 °	-120.711100 °
DWR ID	DWR_NA0010_06_f_2019_89				
Comment Code					
E4 : Repair the levee slope damaged by livestock and prevent large animal access.					
Inspector Comment					
Slope damage has been repaired with loose soil. Monitor for settlement.

View of damage to the waterside slope looking upstream. (Fall 2019)

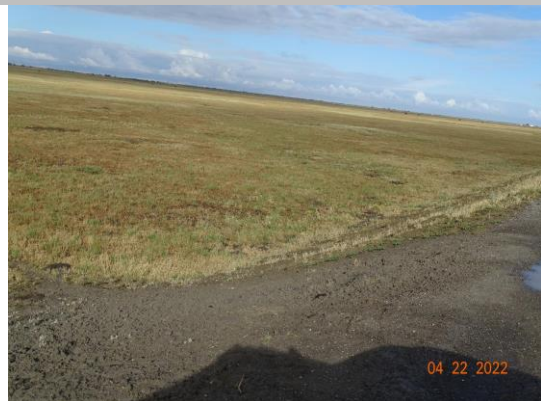
Photo 1 of 1 : SP_2022_NA0010_124_142_20220425_00234.jpg

LM Start	8.33	Rating **	A/W	Issue No.	142
LM End	8.33	Issue Type +	Ma	Location *	LS
Category	Earthen Levee			GPS Latitude/Longitude	
				Start	End
Item	Erosion / Livestock			37.214232 °	37.214232 °
				-120.711025 °	-120.711025 °
DWR ID	DWR_NA0010_06_s_2022_142				
Comment Code					
E4 : Repair the levee slope damaged by livestock and prevent large animal access.					
Inspector Comment

Looking down the levee slope at livestock damage. (Spring 2022)

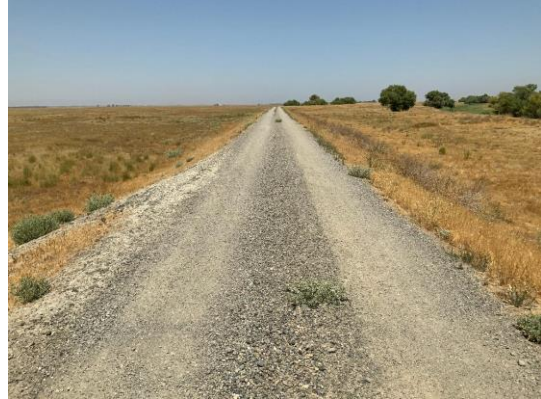
Photo 1 of 3 : UCIP_SP_2022_71117_102254.jpg

Comment Code					
Inspector Comment					
FS_ID:71117 DS_ID:19871 EP_NO: N/A Repair Type: Non-Urgent Crossing Status: Found UCIP Comments: 07/13/2021 Record remains Non-Urgent. DWR DMP internal inspection has found pipe integrity issues. LOF of crossing is between 4.1 and 5. Crossing will be monitored until funding becomes available for rehabilitation. Inside of LS pipe inlet is rusted but no visible holes or deterioration. No permit was found authorizing this encroachment. CVFPB will need to review crossing to determine owner. The UCIP inspection was completed with GEI staff, P. Espinoza. (H. Dunn ? GEI) 04/18/2014 Need to contact owner. Sediment buildup in pipe visible on landward side--recommend clearing. Good candidate for pressure test or video inspection due to signs of heavy corrosion. If no leaks after tests this crossing would be a good candidate for rehabilitation. (O. Magana - DWR UCIP) FIELD_STRUCT_DESC: 24-inch corrugated metal gravity drainage pipe (CMP) through the levee, 9.2 feet below the crown. Flap gate on the waterside (WS) end. Concrete headwall on each end. [Additional Reference(s): DWR Levee Log, 2002, (HLM 8.51). USACE San Joaquin O&M Manual, Unit No. 601, Part No. 1, 1967, Amended in 1978, Revised 20 June 1985, (HLM 8.51). DWR As-Built Specification No. 61-01, Sheet No. 51, 7 March 1961, (HLM 8.51)]. FS Date: 7/13/2021

Levee crown.

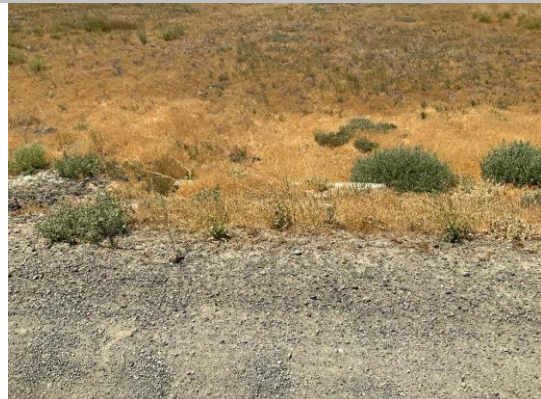
Photo 2 of 3 : UCIP_SP_2022_71117_102255.jpg

LS view: Headwall visible at toe from crown.

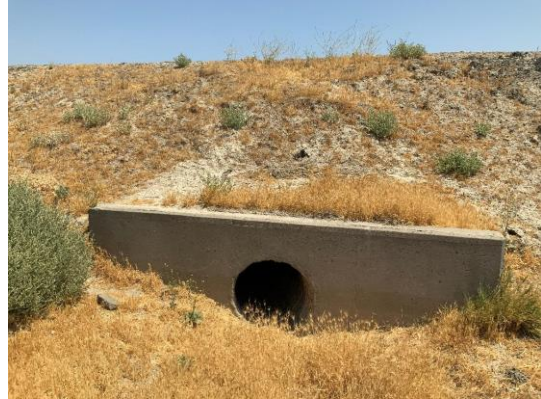
Photo 3 of 3 : UCIP_SP_2022_71117_102256.jpg

LS view: Headwall and slope at toe.

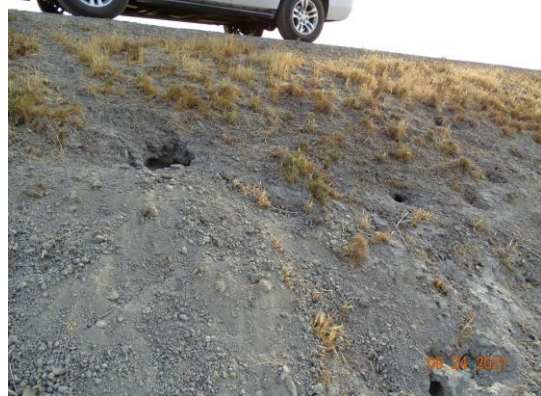
Photo 1 of 1 : SP_2022_NA0010_124_121_20220308_00044.jpg

LM Start	8.61	Rating **	M	Issue No.	121
LM End	8.69	Issue Type +	Ma	Location *	LS
Category	Earthen Levee			GPS Latitude/Longitude	
				Start	End
Item	Animal Control			37.211700 °	37.210809 °
				-120.706976 °	-120.706106 °
DWR ID	DWR_NA0010_06_f_2021_121				
Comment Code					
A1 : Exterminate rodents and backfill and compact or grout burrows.					
Inspector Comment

Looking at rodent holes in the landside slope. (Fall 2021)

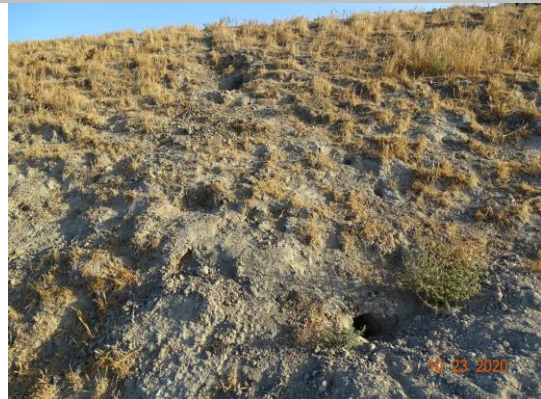
Photo 1 of 1 : SP_2022_NA0010_124_103_20220308_00032.jpg

LM Start	9.67	Rating **	M	Issue No.	103
LM End	9.71	Issue Type +	Ma	Location *	LS
Category	Earthen Levee			GPS Latitude/Longitude	
				Start	End
Item	Animal Control			37.200934 °	37.200836 °
				-120.694084 °	-120.693406 °
DWR ID	DWR_NA0010_06_f_2020_103				
Comment Code					
A3 : No rodents visible, but rodent burrows visible; need to backfill and compact or grout burrows.					
Inspector Comment

Rodent holes in the landside slope. (Fall 2020)

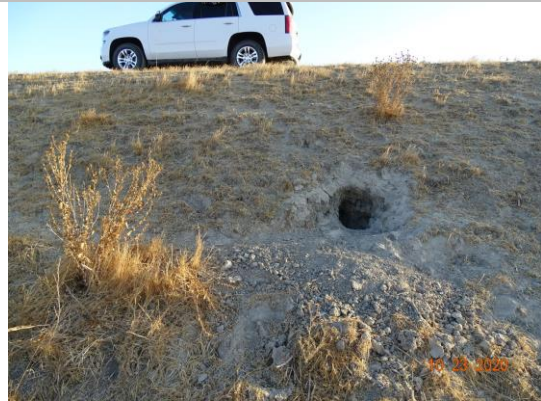
Photo 1 of 1 : SP_2022_NA0010_124_102_20220308_00031.jpg

LM Start	10.12	Rating **	U	Issue No.	102
LM End	10.12	Issue Type +	Ma	Location *	LS
Category	Earthen Levee			GPS Latitude/Longitude	
				Start	End
Item	Animal Control			37.196845 °	37.196845 °
				-120.687892 °	-120.687892 °
DWR ID	DWR_NA0010_06_f _ 2020_102				
Comment Code					
A3 : No rodents visible, but rodent burrows visible; need to backfill and compact or grout burrows.					
Inspector Comment

View of large animal burrow in the landside slope. (Fall 2020)

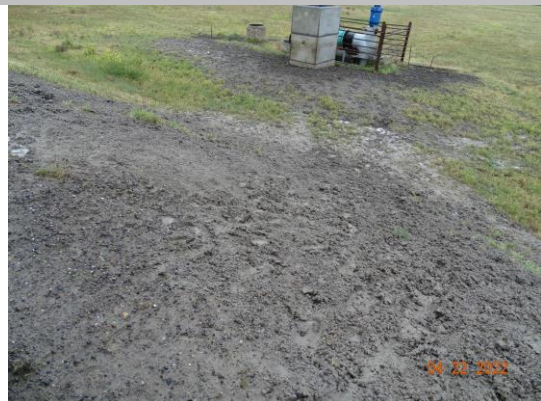
Photo 1 of 1 : SP_2022_NA0010_124_141_20220425_00235.jpg

LM Start	10.96	Rating **	A/W	Issue No.	141
LM End	10.96	Issue Type +	Ma	Location *	LS
Category	Earthen Levee			GPS Latitude/Longitude	
				Start	End
Item	Erosion / Livestock			37.187999 °	37.187999 °
				-120.677522 °	-120.677522 °
DWR ID	DWR_NA0010_06_s_2022_141				
Comment Code					
E4 : Repair the levee slope damaged by livestock and prevent large animal access.					
Inspector Comment

View of damage to the landside slope. (Spring 2022)

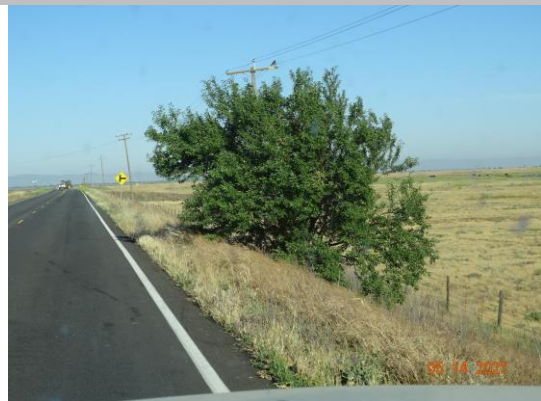
Photo 1 of 1 : SP_2022_NA0010_124_14_20220308_00003.jpg

LM Start	11.49	Rating **	M	Issue No.	14
LM End	11.49	Issue Type +	Ma	Location *	WS
Category	Earthen Levee			GPS Latitude/Longitude	
				Start	End
Item	Trim / Thin Trees			37.186189 °	37.186189 °
				-120.668476 °	-120.668476 °
DWR ID	DWR_NA0010_06_s_2015_14				
Comment Code					
T1 : Trim and thin trees to at least five feet above ground level to allow visibility of the ground and room to flood fight.					
Inspector Comment					
Almond tree located along Sandy Mush Road on waterside slope.

Looking west at tree on waterward slope. (Spring 2021)

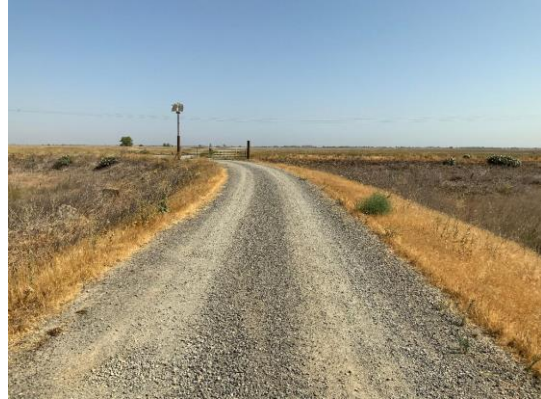
Photo 1 of 3 : UCIP_SP_2022_71151_102330.jpg

Comment Code						
Inspector Comment						
FS_ID:71151 DS_ID:19876 EP_NO: N/A Repair Type: Non-Urgent Crossing Status: Found UCIP Comments: 07/13/2021 The record remains Non-Urgent. Dense vegetation over LS inlet and WS outlet, recommend removal of vegetation from both sides. Limited inspection of both inlet and outlet. No permit was found authorizing this encroachment. CVFPB will need to review crossing to determine owner. The UCIP inspection was completed with GEI staff, P. Espinoza. (H. Dunn ? GEI) 04/17/2014 Clear debris from waterward and landward toes. (O. Magana - DWR UCIP) FIELD_STRUCT_DESC: 36-inch corrugated metal gravity drainage pipe (CMP) through the levee, 17.0 feet below the crown. Slide gate in a pipe riser unit on the waterside (WS) slope. [Additional Reference(s): DWR Levee Log, 2002, (HLM 11.83). USACE San Joaquin O&M Manual, Unit No. 601, Part No. 1, 1967, Amended in 1978, Revised 20 June 1985, (HLM 11.82). DWR As-Built Specification No. 59-01, Sheet No. 66, 10 December 1958, (HLM 11.82)]. FS Date: 7/13/2021

Levee crown.

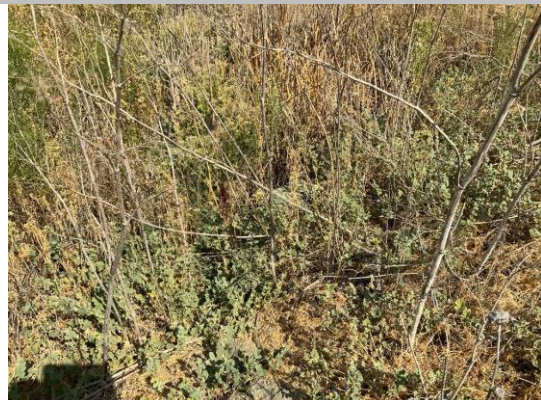
Photo 2 of 3 : UCIP_SP_2022_71151_102328.jpg

WS view: Flapgate barely visible under dense vegetation at toe.

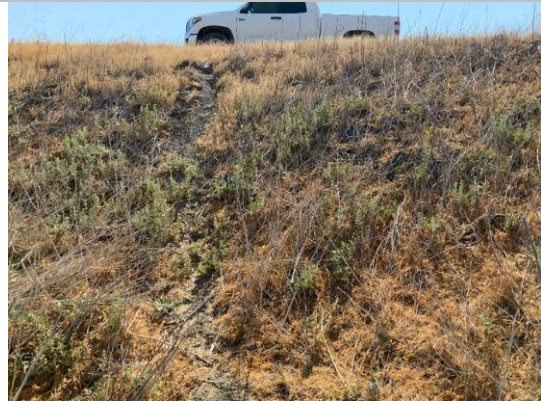
Photo 3 of 3 : UCIP_SP_2022_71151_102329.jpg

LS view: Slope from toe.

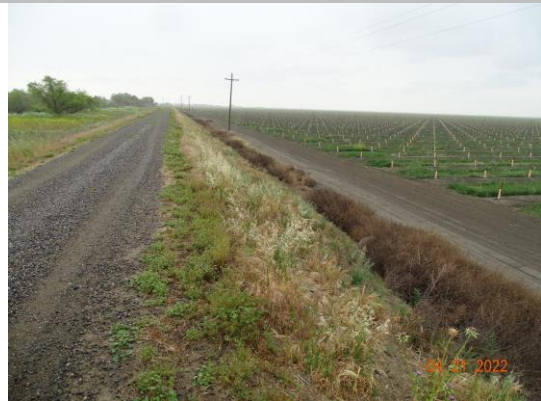
Photo 1 of 1 : SP_2022_NA0010_124_139_20220425_00236.jpg

LM Start	11.76	Rating **	M	Issue No.	139
LM End	13.06	Issue Type +	Ma	Location *	LS
Category	Earthen Levee			GPS Latitude/Longitude	
				Start	End
Item	Vegetation			37.185221 °	37.171704 °
				-120.664567 °	-120.657939 °
DWR ID	DWR_NA0010_06_s_2022_139				
Comment Code					
V1 : Control annual grass and weeds on the levee slopes and easements.					
Inspector Comment

Looking upstream along the landside slope. (Spring 2022)

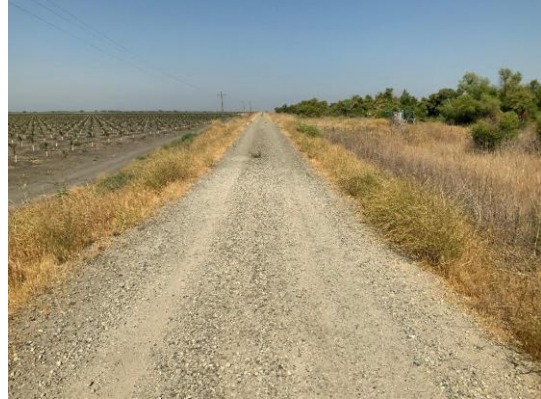
Photo 1 of 3 : UCIP_SP_2022_71152_102335.jpg

Comment Code						
Inspector Comment						
FS_ID:71152 DS_ID:19877 EP_NO: N/A Repair Type: Non-Urgent Crossing Status: Found UCIP Comments: 07/13/2021 The record remains Non-Urgent. Partial cover on WS riser, recommend repair for safety reasons. Limited inspection due to LS pipe inlet being overed with vegetation, headwall barely visible, recommend removal. WS outlet not found, possibly buried under dirt or vegetaion. Recommend removal of vegetation and dirt to uncover WS pipe outlet. No permit was found authorizing this encroachment. CVFPB will need to review crossing to determine owner. The UCIP inspection was completed with GEI staff, P. Espinoza. (H. Dunn ? GEI) 04/17/2014 Not accessible--crossing is buried on landward side. Need to contact owner to determine status. (O. Magana - DWR UCIP) FIELD_STRUCT_DESC: 24-inch corrugated metal gravity drainage pipe (CMP) through the levee, 10.8 feet below the crown. Flap gate on the waterside (WS) end. [Additional Reference(s): DWR Levee Log, 2002, (HLM 13.31). USACE San Joaquin O&M Manual, Unit No. 601, Part No. 1, 1967, Amended in 1978, Revised 20 June 1985, (HLM 13.30). DWR As-Built Specification No. 59-01, Sheet No. 67, 10 December 1958, (HLM 13.30)]. FS Date: 7/13/2021

Levee crown.

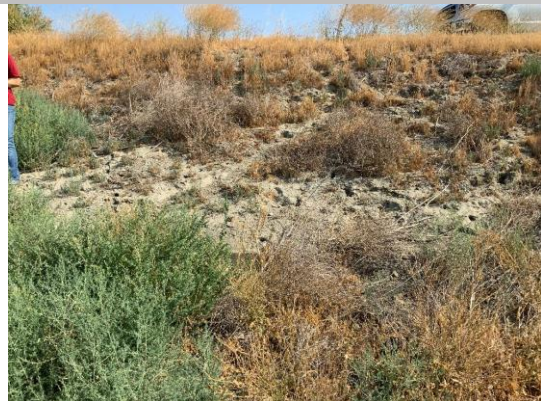
Photo 2 of 3 : UCIP_SP_2022_71152_102334.jpg

LS view: Slope from toe.

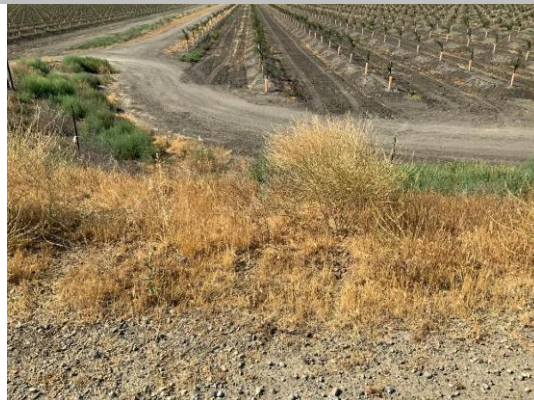
Photo 3 of 3 : UCIP_SP_2022_71152_102339.jpg

LS view: Toe from crown.

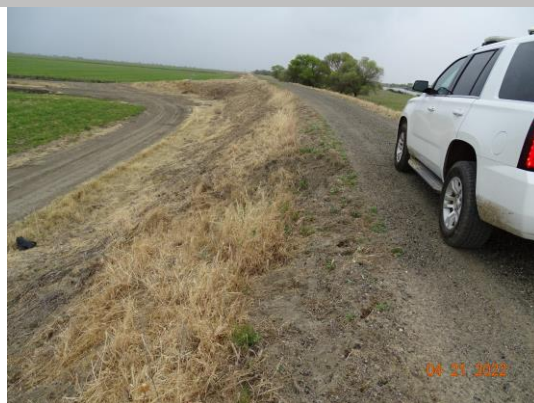
Photo 1 of 1 : SP_2022_NA0010_124_120_20220429_00238.jpg

LM Start	14.00	Rating **	U	Issue No.	120
LM End	14.00	Issue Type +	Ma	Location *	LS
Category	Earthen Levee			GPS Latitude/Longitude	
				Start	End
Item	Slope Stability			37.171591 °	37.171591 °
				-120.640938 °	-120.640938 °
DWR ID	DWR_NA0010_06_f_2021_120				
Comment Code					
S1 : Repair slope instability.					
Inspector Comment					
Caving has eaten approximately 1 foot into the levee crown.

View of slope stability issue on the landside slope. (Spring 2022)

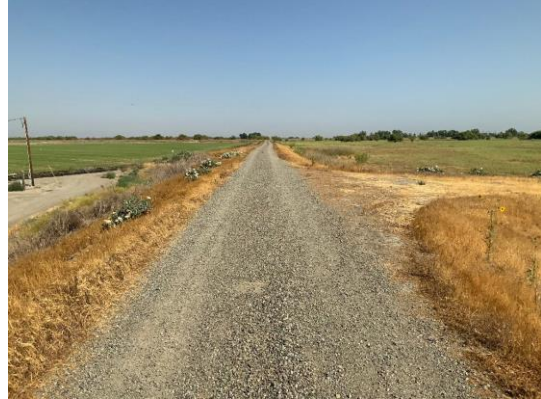
Photo 1 of 3 : UCIP_SP_2022_71153_102392.jpg

Comment Code					
Inspector Comment					
FS_ID:71153 DS_ID:19878 EP_NO: N/A Repair Type: Non-Urgent Crossing Status: Found UCIP Comments: 07/13/2021 The record remains Non-Urgent. Limited inspection due to LS pipe inlet not being found, assuming its completely buried. Recommend removing dirt and vegetation to find alignment and confirming with owner on the status of this pipe. No permit was found authorizing this encroachment. CVFPB will need to review crossing to determine owner. The UCIP inspection was completed with GEI staff, P. Espinoza. (H. Dunn ? GEI) 04/17/2014 Not accessible--crossing is buried on landward side. Need to contact owner to determine status. (O. Magana - DWR UCIP) FIELD_STRUCT_DESC: 24-inch corrugated metal gravity drainage pipe (CMP) through the levee, 12.3 feet below the crown. Flap gate on the waterside (WS) end. [Additional Reference(s): DWR Levee Log, 2002 (HLM 14.45). USACE San Joaquin O&M Manual, Unit No. 601, Part No. 1, 1967, Amended in 1978, Revised 20 June 1985, (HLM 14.44). DWR As-Built Specification No. 59-01, Sheet No. 68, 10 December 1958, (HLM 14.44)]. FS Date: 7/13/2021

Levee crown.

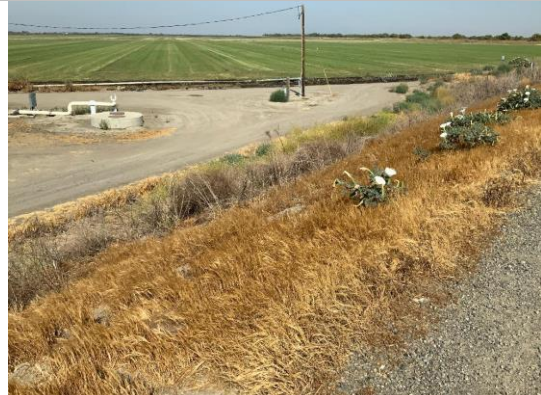
Photo 2 of 3 : UCIP_SP_2022_71153_102396.jpg

LS view: Slope from crown, no pipe visible.

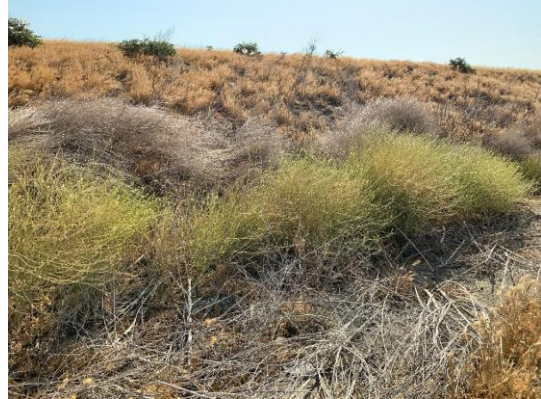
Photo 3 of 3 : UCIP_SP_2022_71153_102397.jpg

LS view: Slope from toe, no pipe visible.

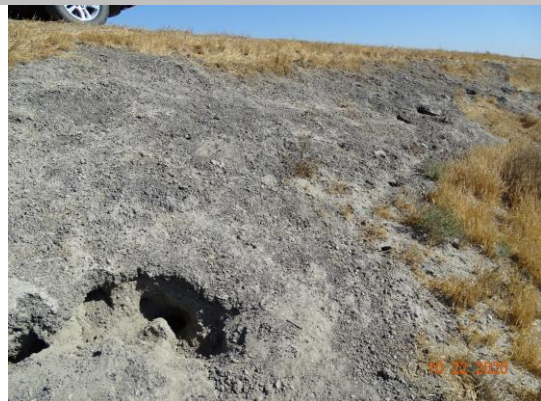
Photo 1 of 1 : SP_2022_NA0010_124_98_20220308_00029.jpg

LM Start	14.37	Rating **	A/W	Issue No.	98
LM End	14.37	Issue Type +	Ma	Location *	WS
Category	Earthen Levee			GPS Latitude/Longitude	
				Start	End
Item	Animal Control			37.167740 °	37.167740 °
				-120.636282 °	-120.636282 °
DWR ID	DWR_NA0010_06_f _ 2020_98				
Comment Code					
A3 : No rodents visible, but rodent burrows visible; need to backfill and compact or grout burrows.					
Inspector Comment

Looking upstream along the waterside slope. (Fall 2020)

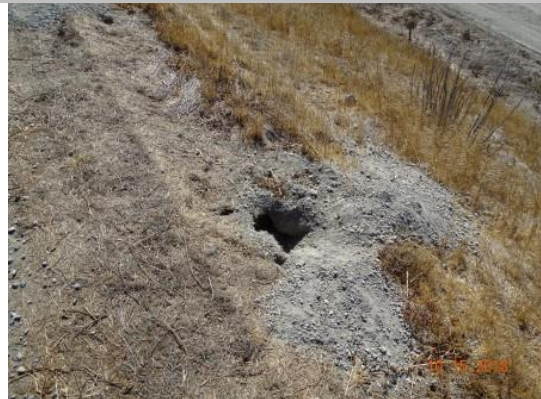
Photo 1 of 1 : SP_2022_NA0010_124_101_20220308_00030.jpg

LM Start	14.63	Rating **	A/W	Issue No.	101
LM End	14.64	Issue Type +	Ma	Location *	LS
Category	Earthen Levee			GPS Latitude/Longitude	
				Start	End
Item	Animal Control			37.164871 °	37.164824 °
				-120.633222 °	-120.633167 °
DWR ID	DWR_NA0010_06_f_2018_101				
Comment Code					
A3 : No rodents visible, but rodent burrows visible; need to backfill and compact or grout burrows.					
Inspector Comment					
Burrows are located along landside shoulder.

View of rodent hole on landside shoulder. (Fall 2018)

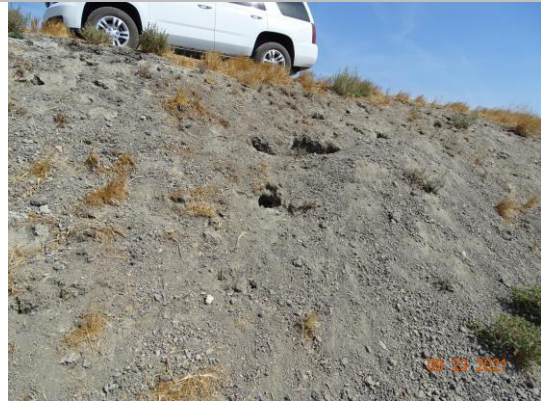
Photo 1 of 1 : SP_2022_NA0010_124_124_20220308_00046.jpg

LM Start	15.31	Rating **	U	Issue No.	124
LM End	15.70	Issue Type +	Ma	Location *	LS
Category	Earthen Levee			GPS Latitude/Longitude	
				Start	End
Item	Animal Control			37.159932 °	37.157217 °
				-120.622810 °	-120.618915 °
DWR ID	DWR_NA0010_06_s_2012_124				
Comment Code					
A1 : Exterminate rodents and backfill and compact or grout burrows.					
Inspector Comment

Large rodent burrows observed in the landside slope. (Fall 2021)

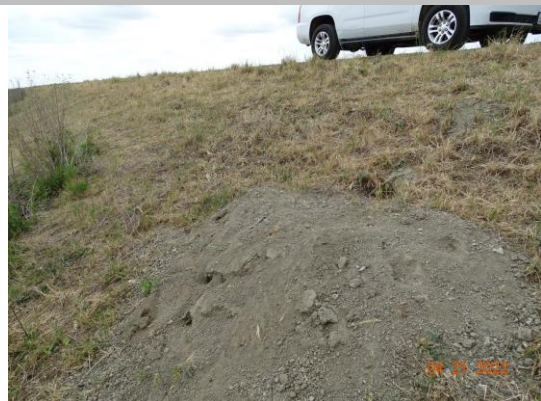
Photo 1 of 1 : SP_2022_NA0010_124_118_20220429_00240.jpg

LM Start	15.32	Rating **	M	Issue No.	118
LM End	15.32	Issue Type +	Ma	Location *	WS
Category	Earthen Levee			GPS Latitude/Longitude	
				Start	End
Item	Animal Control			37.159815 °	37.159815 °
				-120.622513 °	-120.622513 °
DWR ID	DWR_NA0010_06_s_2022_118				
Comment Code					
A1 : Exterminate rodents and backfill and compact or grout burrows.					
Inspector Comment

View of rodent holes on the waterside slope. (Spring 2022)

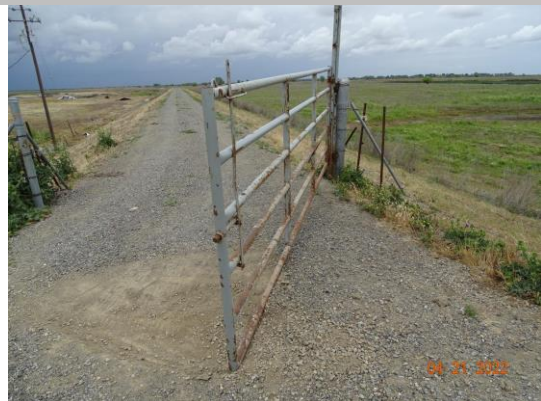
Photo 1 of 1 : SP_2022_NA0010_124_137_20220429_00241.jpg

LM Start	15.66	Rating **	M	Issue No.	137
LM End	15.66	Issue Type +	Ma	Location *	CR
Category	Earthen Levee			GPS Latitude/Longitude	
				Start	End
Item	Access Gates			37.157108 °	37.157108 °
				-120.617451 °	-120.617451 °
DWR ID	DWR_NA0010_06_s_2022_137				
Comment Code					
Inspector Comment					
New gate installed does not have enough clearance above the levee crown to fully open. This a possible access issue for larger vehicles. Recommend reinstalling or replacing.

View of access gate that cannot fully open and is damaging the levee crown. (Spring 2022)

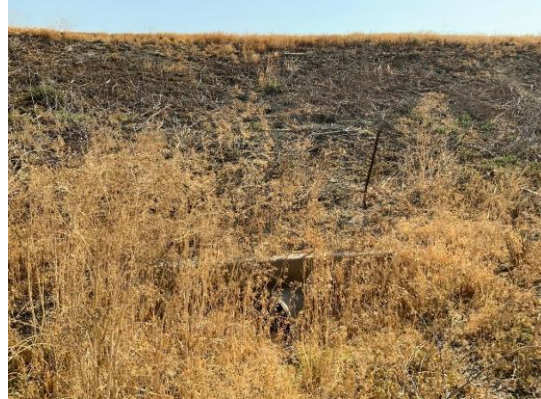
Photo 3 of 3 : UCIP_SP_2022_71133_102350.jpg

LS view: Headwall visible at toe.

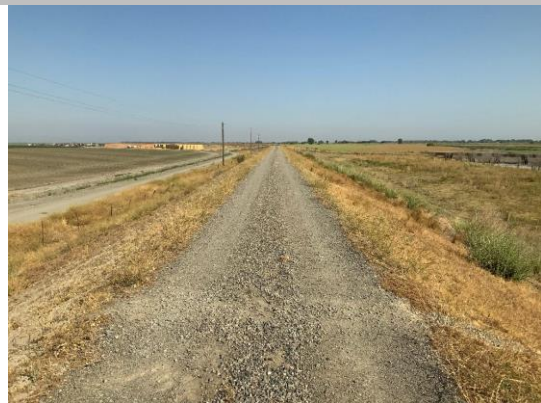
Photo 1 of 3 : UCIP_SP_2022_71134_102362.jpg

FS_ID:71134
DS_ID:19885
EP_NO: N/A
Repair Type: Non-Urgent
Crossing Status: Found
UCIP Comments: 07/13/2021 The record remains Non-Urgent. LS pipe inlet was underwater at time of inspection. WS flapgate was buried under sediment, limited inspection on both ends. Recommend removal of sediment covering flapgate on WS. No permit was found authorizing this encroachment. CVFPB will need to review crossing to determine owner. The UCIP inspection was completed with GEI staff, P. Espinoza. (H. Dunn ? GEI) 04/17/2014 Need to contact owner to determine status of crossing. Waterward side is buried and not accessible. Landward side headwall is blocked by dense vegetation. Recommend confirming status of flap gate on waterward side and removing dense vegetation form landward side. (O. Magana - DWR UCIP)
FIELD_STRUCT_DESC: 36-inch corrugated metal gravity drainage pipe (CMP) through the levee, 16.6 feet below the crown. Flap gate on the waterside (WS) end. [Additional Reference(s): DWR Levee Log, 2002, (HLM 15.93). USACE San Joaquin O&M Manual, Unit No. 601, Part No. 1, 1967, Amended in 1978, Revised 20 June 1985, (HLM 15.91). DWR As-Built Specification No. 59-01, Sheet No. 69, 10 December 1958, (HLM 15.91)].

Levee crown.

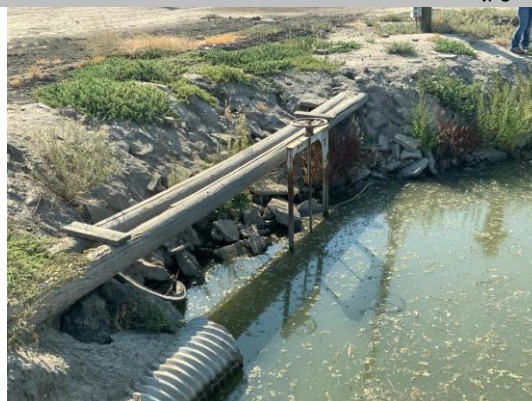
Photo 2 of 3 : UCIP_SP_2022_71134_102365.jpg

LS view: Closeup of slidegate underwater at toe.

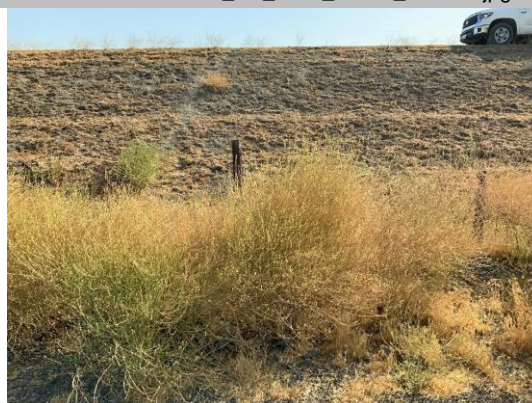
Photo 3 of 3 : UCIP_SP_2022_71134_102364.jpg

LS view: Slope from toe.

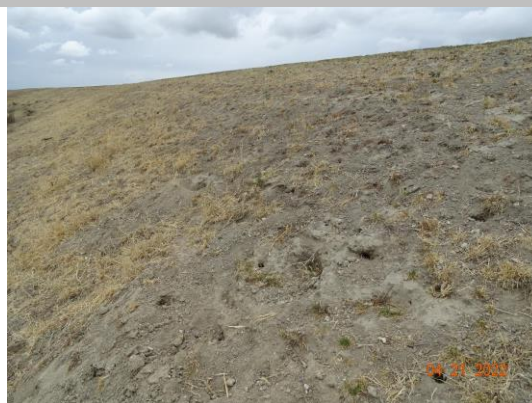
Photo 1 of 1 : SP_2022_NA0010_124_115_20220429_00242.jpg

LM Start	17.10	Rating **	M	Issue No.	115
LM End	17.13	Issue Type +	Ma	Location *	LS
Category	Earthen Levee			GPS Latitude/Longitude	
				Start	End
Item	Animal Control			37.141678 °	37.141305 °
				-120.600221 °	-120.599949 °
DWR ID	DWR_NA0010_06_f_2021_115				
Comment Code					
A1 : Exterminate rodents and backfill and compact or grout burrows.					
Inspector Comment

Looking along the landside slope at rodent burrows. (Spring 2022)
