**Flood Control Project Maintenance
Levee Inspections**

Maintenance Issue Types Only, Levee Inspection Report By Mile - Spring 2022

Lower San Joaquin Levee District

Waterway	Bank	Unit Miles	Inspection Start/End	Inspector
Unit No. 01 San Joaquin River	Right	22.52	04/05/2022 04/05/2022	Corey Fujitani

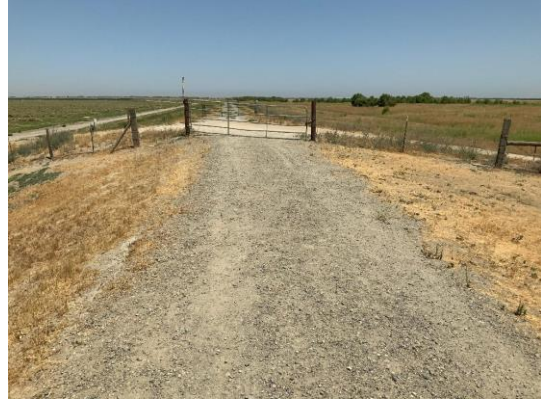
Photo 1 of 3 : UCIP_SP_2022_71137_101418.jpg

Comment Code						
Inspector Comment						
FS_ID:71137 DS_ID:19887 EP_NO: N/A Repair Type: Non-Urgent Crossing Status: Found UCIP Comments: 07/12/2021 The record remains Non-Urgent. LS pipe inlet filled with sediment, recommend removal. WS flapgate has some vegetation over it, recommend removal. Limited inspection on both WS and LS. No permit was found authorizing this encroachment. CVFPB will need to review crossing to determine owner. The UCIP inspection was completed with GEI staff, P. Espinoza. (H. Dunn ? GEI)						
04/17/2014 Sediment build up on landward side toe -- debris blockage. No photos available. Recommend taking photos of crossing. (O. Magana - DWR UCIP) FIELD_STRUCT_DESC: 24-inch corrugated metal gravity drainage pipe (CMP) through the levee, 11.5 feet below the crown. Flap gate on the waterside (WS) end. [Additional Reference(s): DWR Levee Log, 2002, (HLM 18.29). USACE San Joaquin O&M Manual, Unit No. 601, Part No. 1, 1967, Amended in 1978, Revised 20 June 1985, (HLM 18.27). DWR As-Built Specification No. 59-01, Sheet No. 70, 10 December 1958, (HLM 18.27)]. FS Date: 7/13/2021

Levee crown.

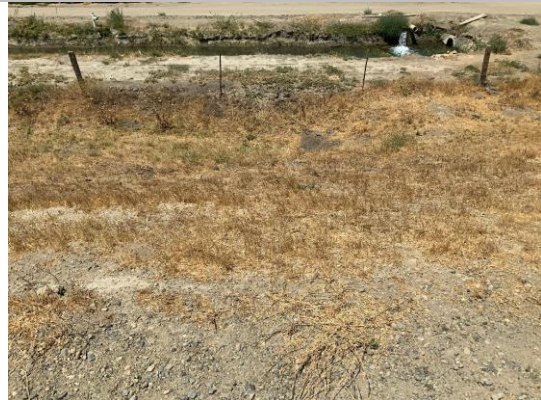
Photo 2 of 3 : UCIP_SP_2022_71137_101419.jpg

LS view: Toe from crown.

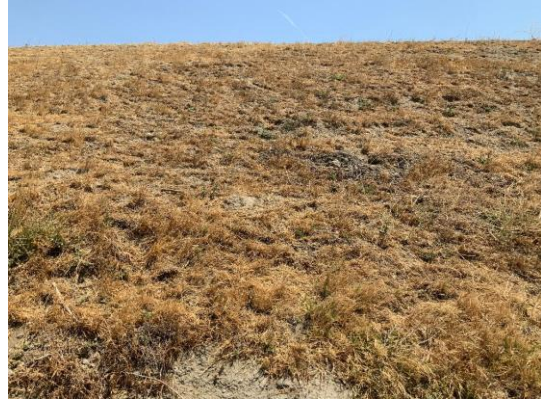
Photo 3 of 3 : UCIP_SP_2022_71137_101420.jpg

LS view: Slope from toe.

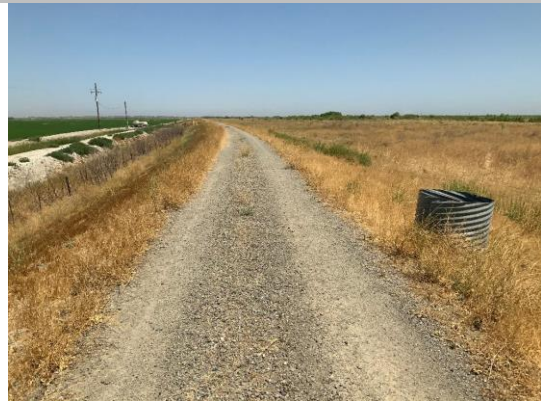
Photo 1 of 3 : UCIP_SP_2022_71139_101558.jpg

FS_ID:71139
DS_ID:19889
EP_NO: N/A
Repair Type: Non-Urgent
Crossing Status: Found
UCIP Comments: 07/12/2021 The record remains Non-Urgent. Barbed wire over LS end, could not inspect closely. No cover over WS riser, causing safety hazard. Slightly warped edges on both WS and LS pipe inlet/outlet. No permit was found authorizing this encroachment. CVFPB will need to review crossing to determine owner. The UCIP inspection was completed with GEI staff, P. Espinoza. (H. Dunn ? GEI)

Levee crown.

04/17/2014 Dense vegetation limits the inspector's visibility to identify signs of pipe failure (leaks) along the landward slope. Recommend removing vegetation along pipe alignment to conduct proper inspection of structure. (O. Magana - DWR UCIP)

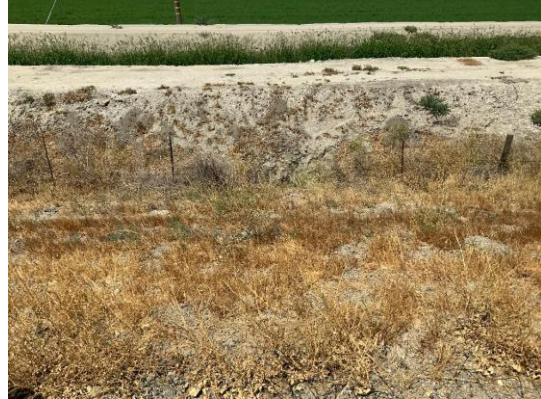
Photo 2 of 3 : UCIP_SP_2022_71139_101559.jpg

LS view: Toe from crown.

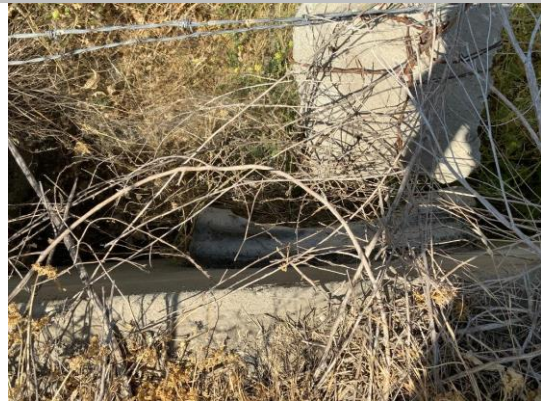
Photo 3 of 3 : UCIP_SP_2022_71139_101560.jpg

LS view: Top of pipe inlet at headwall at toe.

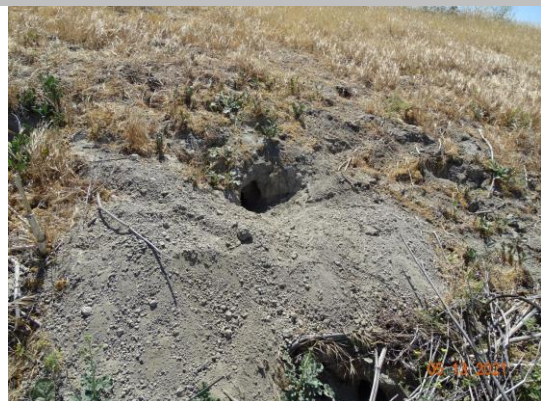
Photo 1 of 1 : SP_2022_NA0010_124_72_20220308_00011.jpg

LM Start	19.07	Rating **	U	Issue No.	72
LM End	19.07	Issue Type +	Ma	Location *	LS
Category	Earthen Levee			GPS Latitude/Longitude	
				Start	End
Item	Animal Control			37.115706 °	37.115706 °
				-120.587036 °	-120.587036 °
DWR ID	DWR_NA0010_06_s_2021_72				
Comment Code					
A1 : Exterminate rodents and backfill and compact or grout burrows.					
Inspector Comment

Large rodent burrows observed in the landside slope. (Spring 2021)

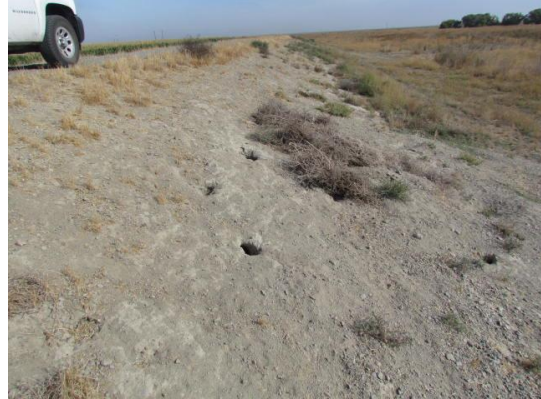
Photo 1 of 1 : SP_2022_NA0010_124_1211_20220308_00053.jpg

LM Start	19.14	Rating **	A/W	Issue No.	1211
LM End	19.14	Issue Type +	Ma	Location *	WS
Category	Earthen Levee			GPS Latitude/Longitude	
				Start	End
Item	Animal Control			37.114793 °	37.114793 °
				-120.587582 °	-120.587582 °
DWR ID	DWR_NA0010_06_s_2022_1211				
Comment Code					
A3 : No rodents visible, but rodent burrows visible; need to backfill and compact or grout burrows.					
Inspector Comment					
Several large rodent holes with more than 2 cubic feet of material were previously noted on the waterside slope.

Looking at several rodent holes on waterward slope. (Fall 2015)

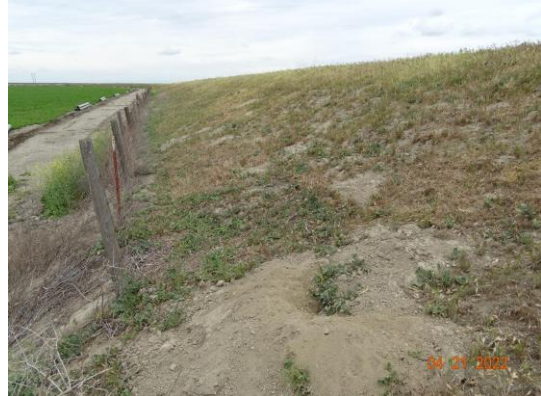
Photo 1 of 1 : SP_2022_NA0010_124_136_20220429_00243.jpg

LM Start	19.22	Rating **	M	Issue No.	136
LM End	19.22	Issue Type +	Ma	Location *	LS
Category	Earthen Levee			GPS Latitude/Longitude	
				Start	End
Item	Animal Control			37.113716 °	37.113716 °
				-120.588225 °	-120.588225 °
DWR ID	DWR_NA0010_06_s_2022_136				
Comment Code					
A3 : No rodents visible, but rodent burrows visible; need to backfill and compact or grout burrows.					
Inspector Comment

Looking downstream along the landside slope at rodent burrows. (Spring 2022)

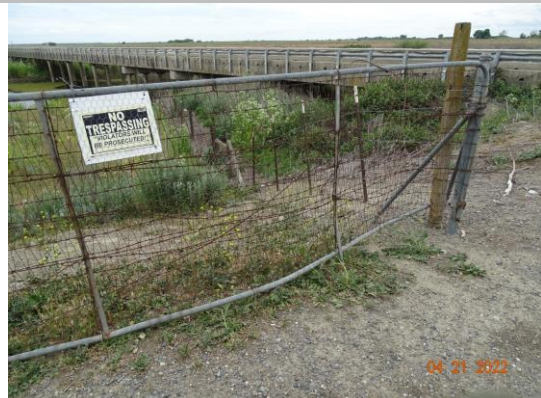
Photo 1 of 1 : SP_2022_NA0010_124_135_20220429_00244.jpg

LM Start	19.23	Rating **	M	Issue No.	135
LM End	19.23	Issue Type +	Ma	Location *	CR
Category	Earthen Levee			GPS Latitude/Longitude	
				Start	End
Item	Access Gates			37.113581 °	37.113581 °
				-120.588310 °	-120.588310 °
DWR ID	DWR_NA0010_06_s_2022_135				
Comment Code					
Inspector Comment					
Bottom of gate has broken off near hinge causing the gate to drag.

View of access gate with a broken bottom hinge. (Spring 2022)

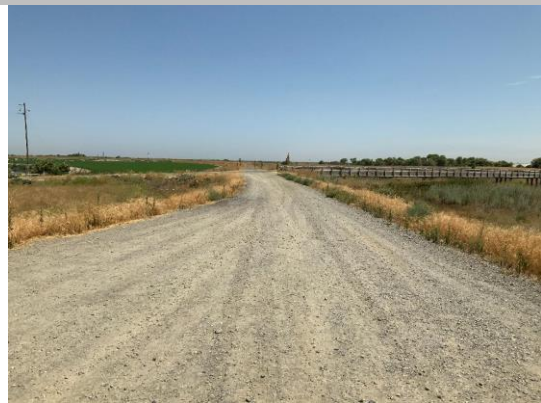
Photo 1 of 3 : UCIP_SP_2022_71140_101574.jpg

Comment Code						
Inspector Comment						
FS_ID:71140 DS_ID:19890 EP_NO: N/A Repair Type: Non-Urgent Crossing Status: Found UCIP Comments: 07/12/2021 The record remains Non-Urgent. WS pipe outlet visible but underwater, unable to inspect closely. LS pipe inlet was not seen, but likely underwater. No permit was found authorizing this encroachment. CVFPB will need to review crossing to determine owner. The UCIP inspection was completed with GEI staff, P. Espinoza. (H. Dunn ? GEI) 04/17/2014 Dense vegetation limits the inspector's visibility to identify signs of pipe failure (leaks) along the slopes. Recommend removing vegetation along pipe alignment to conduct proper inspection of structure. (O. Magana - DWR UCIP) FIELD_STRUCT_DESC: 48-inch corrugated metal gravity drainage pipe (CMP) through the levee, 20.0 feet below the crown. Slide gate in a pipe riser unit on the waterside (WS) slope. Riprap along the landside (LS) slope. [Additional Reference(s): DWR Levee Log, 2002, (HLM 19.36). USACE San Joaquin O&M Manual, Unit No. 601, Part No. 1, 1967, Amended in 1978, Revised 20 June 1985, (HLM 19.36). DWR As-Built Specification No. 59-01, Sheet No. 72, 10 December 1958, (HLM 19.36)]. FS Date: 7/12/2021

Levee crown.

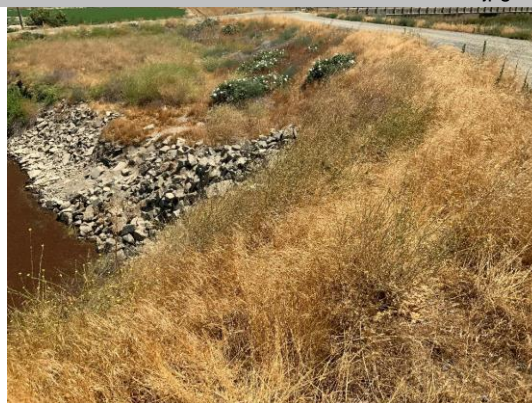
Photo 2 of 3 : UCIP_SP_2022_71140_101575.jpg

LS view: Slope from crown, no pipe visible.

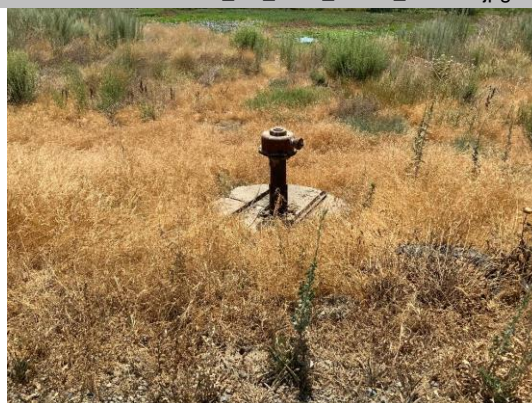
Photo 3 of 3 : UCIP_SP_2022_71140_101576.jpg

WS view: Slidegate visible on slope from crown.

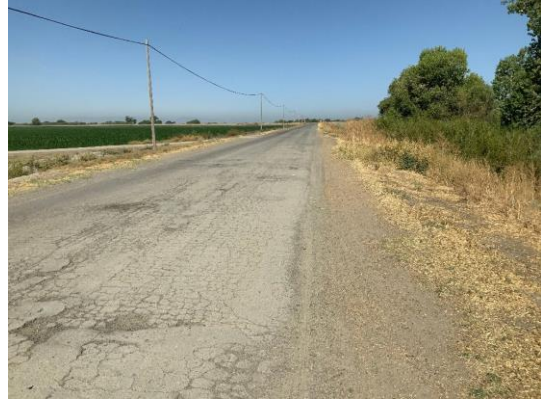
Photo 1 of 3 : UCIP_SP_2022_71141_101582.jpg

Comment Code						
Inspector Comment						
FS_ID:71141 DS_ID:19891 EP_NO: N/A Repair Type: Non-Urgent Crossing Status: Found UCIP Comments: 07/12/2021 The record remains Non-Urgent. Limited inspection due to dense vegetation on LS and WS ends, LS headwall just barely visible, recommend removal of vegetation. No permit was found authorizing this encroachment. CVFPB will need to review crossing to determine owner. The UCIP inspection was completed with GEI staff, P. Espinoza. (H. Dunn ? GEI) 04/17/2014 Dense vegetation limits the inspector's visibility to identify signs of pipe failure (leaks) along the slopes. Recommend removing vegetation along pipe alignment to conduct proper inspection of structure. (O. Magana - DWR UCIP) FIELD_STRUCT_DESC: 30-inch by 30-inch reinforced concrete box gravity drainage culvert (RCBC) through the levee, 14.0 feet below the crown. Flap gate on the waterside (WS) end. [Additional Reference(s): DWR Levee Log, 2002, (HLM 19.82). USACE San Joaquin O&M Manual, Unit No. 601, Part No. 1, 1967, Amended in 1978, Revised 20 June 1985, (HLM 19.85). DWR As-Built Specification No. 59-01, Sheet No. 73, 10 December 1958, (HLM 19.85)]. FS Date: 7/12/2021

Levee crown.

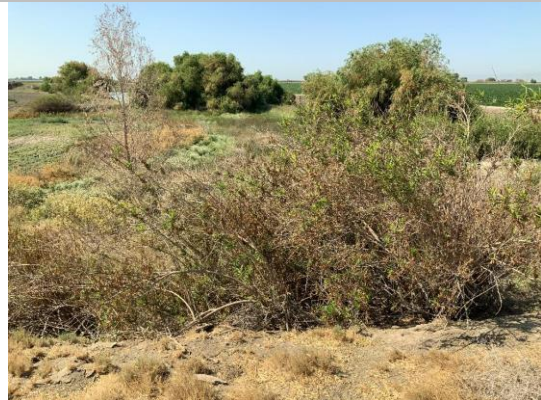
Photo 2 of 3 : UCIP_SP_2022_71141_101578.jpg

LS view: Toe from crown.

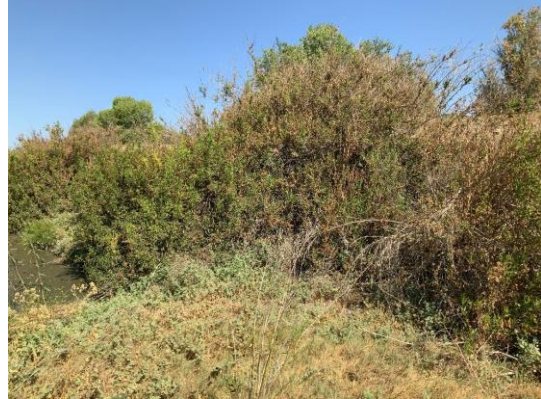
Photo 3 of 3 : UCIP_SP_2022_71141_101579.jpg

LS view: Dense vegetation over pipe inlet at toe, pipe not visible.

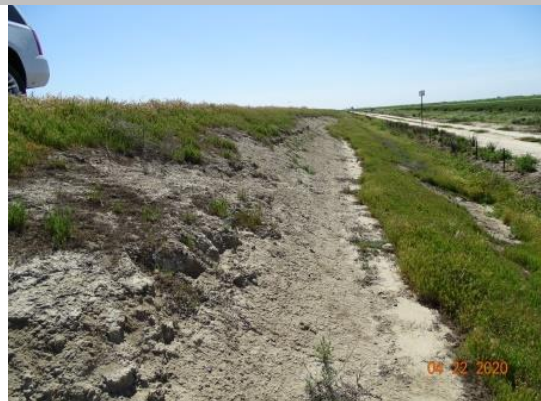
Photo 1 of 1 : SP_2022_NA0010_124_1209_20220308_00052.jpg

LM Start	20.79	Rating **	M	Issue No.	1209
LM End	21.19	Issue Type +	Ma	Location *	LS
Category	Earthen Levee			GPS Latitude/Longitude	
				Start	End
Item	Erosion / Livestock			37.113107 °	37.108653 °
				-120.563782 °	-120.558977 °
DWR ID	DWR_NA0010_06_s_2015_1209				
Comment Code					
E4 : Repair the levee slope damaged by livestock and prevent large animal access.					
Inspector Comment					
Erosion on landside slope greater than 3 inches. Erosion caused by livestock.

Erosion on the landside slope from livestock activity. (Spring 2020)

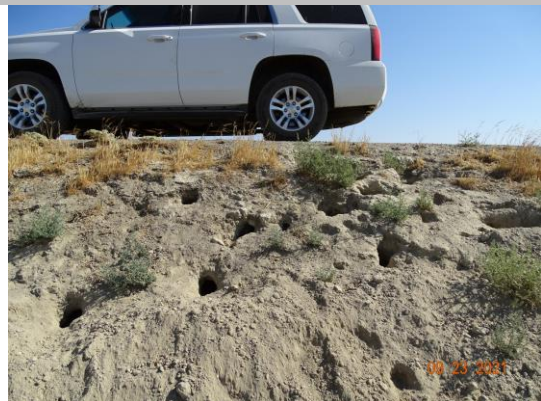
Photo 1 of 1 : SP_2022_NA0010_124_113_20220308_00038.jpg

LM Start	21.30	Rating **	U	Issue No.	113
LM End	21.30	Issue Type +	Ma	Location *	LS
Category	Earthen Levee			GPS Latitude/Longitude	
				Start	End
Item	Animal Control			37.107502 °	37.107502 °
				-120.557813 °	-120.557813 °
DWR ID	DWR_NA0010_06_f_2021_113				
Comment Code					
A3 : No rodents visible, but rodent burrows visible; need to backfill and compact or grout burrows.					
Inspector Comment

Several rodent holes observed at this location. (Fall 2021)

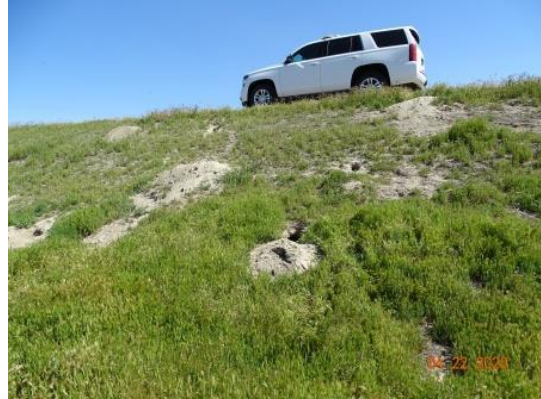
Photo 1 of 1 : SP_2022_NA0010_124_114_20220308_00039.jpg

LM Start	21.39	Rating **	M	Issue No.	114
LM End	21.39	Issue Type +	Ma	Location *	LS
Category	Earthen Levee			GPS Latitude/Longitude	
				Start	End
Item	Animal Control			37.106397 °	37.106397 °
				-120.556727 °	-120.556727 °
DWR ID	DWR_NA0010_06_f _ 2019_114				
Comment Code					
A3 : No rodents visible, but rodent burrows visible; need to backfill and compact or grout burrows.					
Inspector Comment

View of rodent burrows on the landside slope. (Spring 2020)

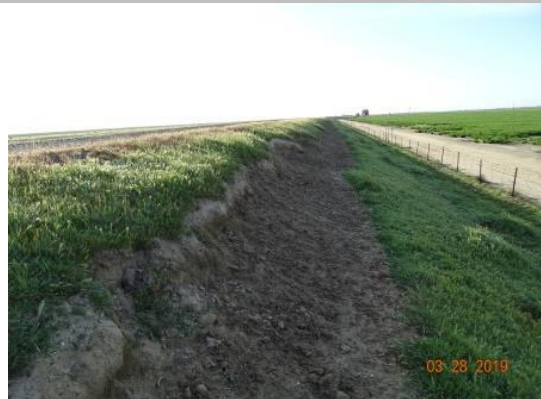
Photo 1 of 1 : SP_2022_NA0010_124_107_20220308_00035.jpg

LM Start	21.71	Rating **	M	Issue No.	107
LM End	21.78	Issue Type +	Ma	Location *	LS
Category	Earthen Levee			GPS Latitude/Longitude	
				Start	End
Item	Erosion / Livestock			37.102844 °	37.102002 °
				-120.553160 °	-120.552314 °
DWR ID	DWR_NA0010_06_f_2018_107				
Comment Code					
E4 : Repair the levee slope damaged by livestock and prevent large animal access.					
Inspector Comment					
Erosion into levee prism due to livestock activities.

View of erosion in landside levee prism. (Spring 2019)

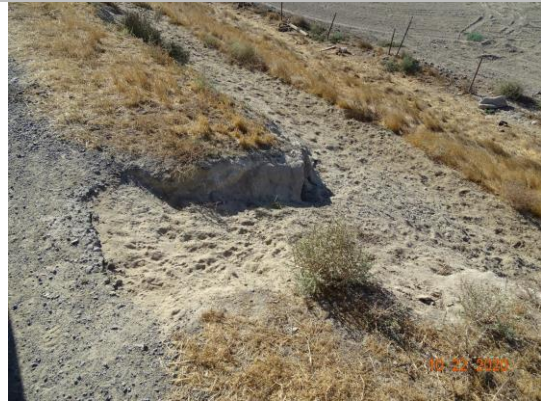
Photo 1 of 1 : SP_2022_NA0010_124_91_20220308_00025.jpg

LM Start	21.82	Rating **	M	Issue No.	91
LM End	22.06	Issue Type +	Ma	Location *	LS
Category	Earthen Levee			GPS Latitude/Longitude	
				Start	End
Item	Erosion / Livestock			37.101617 °	37.098894 °
				-120.551909 °	-120.549178 °
DWR ID	DWR_NA0010_06_f _ 2020_91				
Comment Code					
E4 : Repair the levee slope damaged by livestock and prevent large animal access.					
Inspector Comment

Cattle trail damage to the landside slope and shoulder. (Fall 2020)

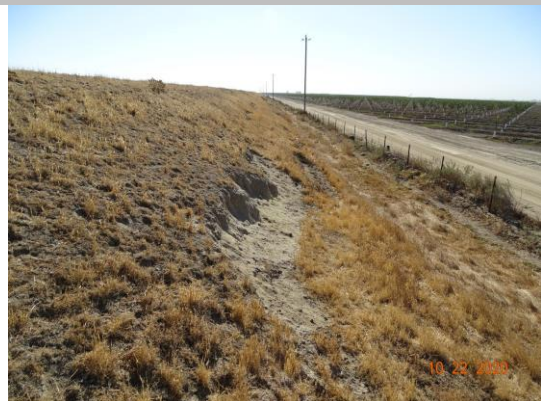
Photo 1 of 1 : SP_2022_NA0010_124_86_20220308_00021.jpg

LM Start	22.09	Rating **	M	Issue No.	86
LM End	22.46	Issue Type +	Ma	Location *	LS
Category	Earthen Levee			GPS Latitude/Longitude	
				Start	End
Item	Erosion / Livestock			37.098524 °	37.094479 °
				-120.548781 °	-120.544435 °
DWR ID	DWR_NA0010_06_f_2017_86				
Comment Code					
E4 : Repair the levee slope damaged by livestock and prevent large animal access.					
Inspector Comment					
Erosion greater than 3 inches on landside slope caused by livestock.

Looking upstream along the landside slope. (Fall 2020)

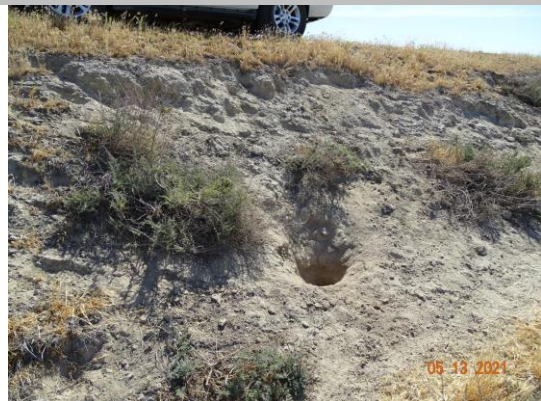
Photo 1 of 1 : SP_2022_NA0010_124_70_20220308_00010.jpg

LM Start	22.15	Rating **	U	Issue No.	70
LM End	22.15	Issue Type +	Ma	Location *	LS
Category	Earthen Levee			GPS Latitude/Longitude	
				Start	End
Item	Animal Control			37.097885 °	37.097885 °
				-120.548108 °	-120.548108 °
DWR ID	DWR_NA0010_06_s_2021_70				
Comment Code					
A3 : No rodents visible, but rodent burrows visible; need to backfill and compact or grout burrows.					
Inspector Comment

View of large rodent burrows in the landside slope. (Spring 2021)

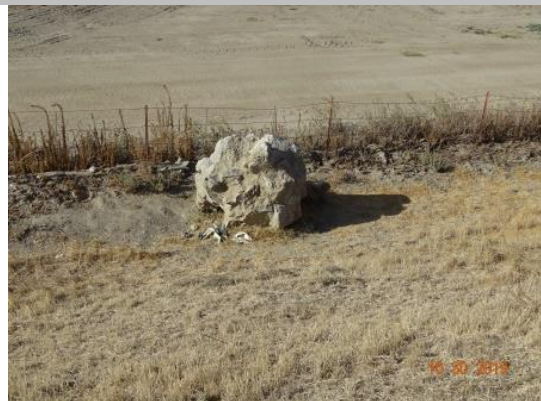
Photo 1 of 1 : SP_2022_NA0010_124_117_20220308_00040.jpg

LM Start	22.87	Rating **	M	Issue No.	117
LM End	22.87	Issue Type +	Ma	Location *	LS
Category	Earthen Levee			GPS Latitude/Longitude	
				Start	End
Item	Encroachments			37.089954 °	37.089954 °
				-120.539535 °	-120.539535 °
DWR ID	DWR_NA0010_06_f_2019_117				
Comment Code					
DE : Debris					
Inspector Comment					
Large block of concrete left on the landside toe.

Large concrete block left on the landside toe. (Fall 2019)

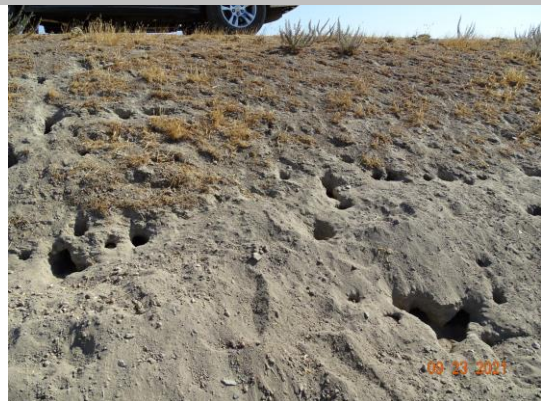
Photo 1 of 1 : SP_2022_NA0010_124_110_20220308_00037.jpg

LM Start	23.11	Rating **	M	Issue No.	110
LM End	23.11	Issue Type +	Ma	Location *	LS
Category	Earthen Levee			GPS Latitude/Longitude	
				Start	End
Item	Animal Control			37.087312 °	37.087312 °
				-120.536662 °	-120.536662 °
DWR ID	DWR_NA0010_06_f_2021_110				
Comment Code					
A3 : No rodents visible, but rodent burrows visible; need to backfill and compact or grout burrows.					
Inspector Comment

View of rodent burrows on the landside slope. (Fall 2021)

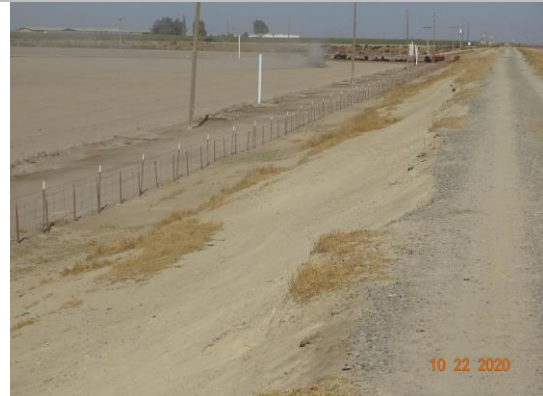
Photo 1 of 1 : SP_2022_NA0010_124_5_20220308_00002.jpg

LM Start	24.36	Rating **	U	Issue No.	5
LM End	25.01	Issue Type +	Ma	Location *	LS
Category	Earthen Levee			GPS Latitude/Longitude	
				Start	End
Item	Erosion / Livestock			37.073621 °	37.066501 °
				-120.521848 °	-120.514193 °
DWR ID	DWR_NA0010_06_s_2012_5				
Comment Code					
E4 : Repair the levee slope damaged by livestock and prevent large animal access.					
Inspector Comment					
Landside erosion and slope instability caused by livestock extends into levee crown. At the worst locations erosion extends 2.5 feet to 3 feet from the shoulder into the crown.

Looking downstream at erosion from livestock. (Fall 2020)

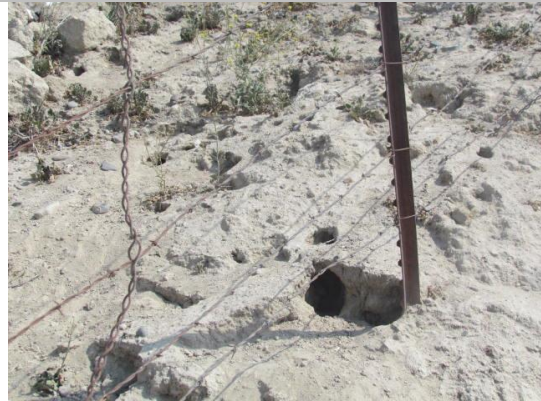
Photo 1 of 1 : SP_2022_NA0010_124_1208_20220308_00051.jpg

LM Start	26.13	Rating **	M	Issue No.	1208
LM End	26.13	Issue Type +	Ma	Location *	LS
Category	Earthen Levee			GPS Latitude/Longitude	
				Start	End
Item	Animal Control			37.054222 °	37.054222 °
				-120.500862 °	-120.500862 °
DWR ID	DWR_NA0010_06_s_2015_1208				
Comment Code					
A3 : No rodents visible, but rodent burrows visible; need to backfill and compact or grout burrows.					
Inspector Comment					
Noted several rodent holes next to and within rock revetment on landside slope.

Rodent holes on landward slope.

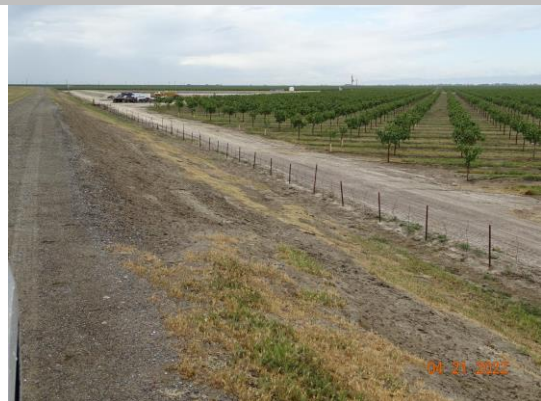
Photo 1 of 1 : SP_2022_NA0010_124_3_20220429_00245.jpg

LM Start	27.43	Rating **	U	Issue No.	3
LM End	27.99	Issue Type +	Ma	Location *	LS
Category	Earthen Levee			GPS Latitude/Longitude	
				Start	End
Item	Erosion / Livestock			37.036955 °	37.032762 °
				-120.484395 °	-120.481078 °
DWR ID	DWR_NA0010_06_s_2012_3				
Comment Code					
E4 : Repair the levee slope damaged by livestock and prevent large animal access.					
Inspector Comment					
Landside erosion and slope instability caused by livestock. Erosion greater than 3" in depth on landside slope. Levee crown has narrowed within this reach.

Looking south along landside slope. (Spring 2022)

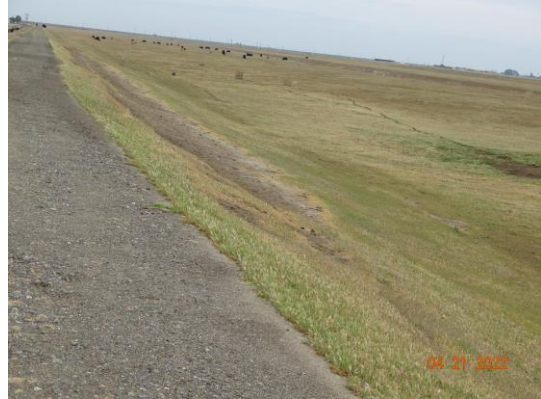
Photo 1 of 1 : SP_2022_NA0010_124_132_20220429_00246.jpg

LM Start	27.65	Rating **	M	Issue No.	132
LM End	27.93	Issue Type +	Ma	Location *	WS
Category	Earthen Levee			GPS Latitude/Longitude	
				Start	End
Item	Erosion / Livestock			37.036856 °	37.033468 °
				-120.484309 °	-120.481709 °
DWR ID	DWR_NA0010_06_s_2022_132				
Comment Code					
E4 : Repair the levee slope damaged by livestock and prevent large animal access.					
Inspector Comment

View of erosion on the waterside slope. (Spring 2022)

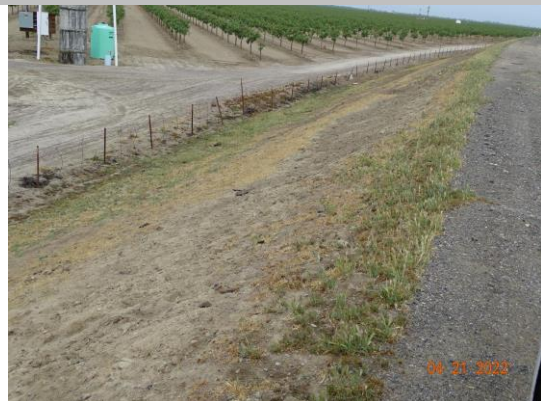
Photo 1 of 1 : SP_2022_NA0010_124_131_20220429_00247.jpg

LM Start	28.18	Rating **	A/W	Issue No.	131
LM End	28.18	Issue Type +	Ma	Location *	LS
Category	Earthen Levee			GPS Latitude/Longitude	
				Start	End
Item	Erosion / Livestock			37.030925 °	37.030925 °
				-120.478368 °	-120.478368 °
DWR ID	DWR_NA0010_06_s_2022_131				
Comment Code					
E4 : Repair the levee slope damaged by livestock and prevent large animal access.					
Inspector Comment

View of damage to the landside slope. (Spring 2022)

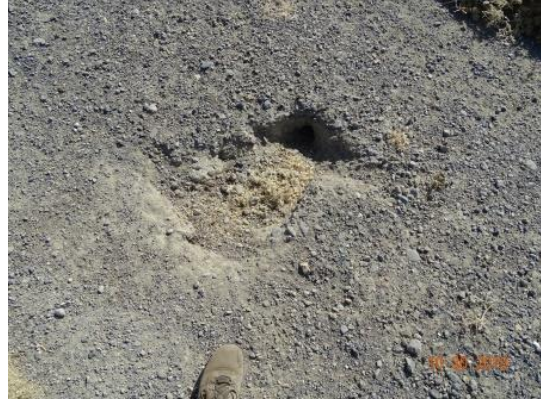
Photo 1 of 1 : SP_2022_NA0010_124_19_20220308_00004.jpg

LM Start	28.47	Rating **	M	Issue No.	19
LM End	28.53	Issue Type +	Ma	Location *	LS
Category	Earthen Levee			GPS Latitude/Longitude	
				Start	End
Item	Animal Control			37.029937 °	37.029977 °
				-120.473384 °	-120.472266 °
DWR ID	DWR_NA0010_06_s_2015_19				
Comment Code					
A3 : No rodents visible, but rodent burrows visible; need to backfill and compact or grout burrows.					
Inspector Comment					
Rodent burrows are also on the crown.

View of rodent burrow in the levee crown. (Fall 2019)

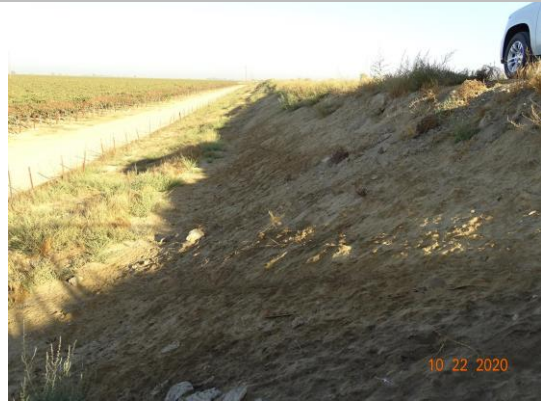
Photo 1 of 1 : SP_2022_NA0010_124_1207_20220308_00050.jpg

LM Start	30.81	Rating **	M	Issue No.	1207
LM End	31.06	Issue Type +	Ma	Location *	LS
Category	Earthen Levee			GPS Latitude/Longitude	
				Start	End
Item	Erosion / Livestock			37.021615 °	37.018428 °
				-120.437587 °	-120.435378 °
DWR ID	DWR_NA0010_06_s_2015_1207				
Comment Code					
E4 : Repair the levee slope damaged by livestock and prevent large animal access.					
Inspector Comment					
Landside erosion greater than 1" in depth and greater than 3" in length. Erosion is caused by livestock traffic.

Looking upstream at livestock damage to the landside slope. (Fall 2020)

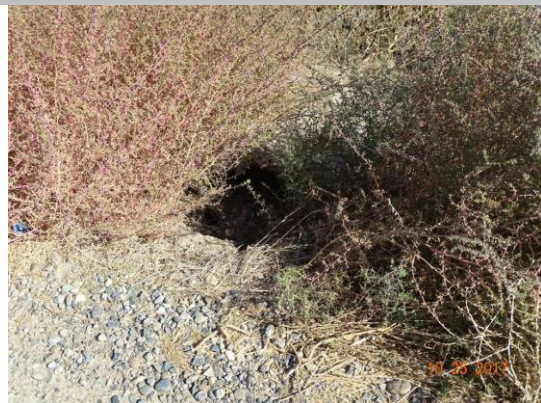
Photo 1 of 1 : SP_2022_NA0010_124_82_20220308_00018.jpg

LM Start	31.14	Rating **	A/W	Issue No.	82
LM End	31.14	Issue Type +	Ma	Location *	WS
Category	Earthen Levee			GPS Latitude/Longitude	
				Start	End
Item	Animal Control			37.017445 °	37.017445 °
				-120.434713 °	-120.434713 °
DWR ID	DWR_NA0010_06_f_2017_82				
Comment Code					
A3 : No rodents visible, but rodent burrows visible; need to backfill and compact or grout burrows.					
Inspector Comment

Looking east at the waterside slope.

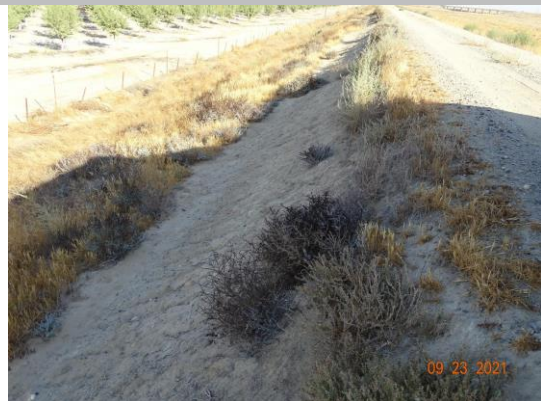
Photo 1 of 1 : SP_2022_NA0010_124_108_20220308_00036.jpg

LM Start	31.50	Rating **	M	Issue No.	108
LM End	31.70	Issue Type +	Ma	Location *	LS
Category	Earthen Levee			GPS Latitude/Longitude	
				Start	End
Item	Erosion / Livestock			37.012830 °	37.010335 °
				-120.431523 °	-120.429817 °
DWR ID	DWR_NA0010_06_f_2021_108				
Comment Code					
E4 : Repair the levee slope damaged by livestock and prevent large animal access.					
Inspector Comment

View of the landside slope looking downstream. (Fall 2021)

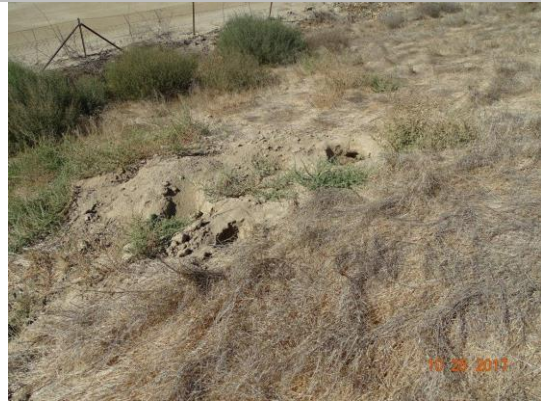
Photo 1 of 1 : SP_2022_NA0010_124_81_20220308_00017.jpg

LM Start	32.00	Rating **	U	Issue No.	81
LM End	32.00	Issue Type +	Ma	Location *	LS
Category	Earthen Levee			GPS Latitude/Longitude	
				Start	End
Item	Animal Control			37.007007 °	37.007007 °
				-120.426179 °	-120.426179 °
DWR ID	DWR_NA0010_06_f _ 2017_81				
Comment Code					
A3 : No rodents visible, but rodent burrows visible; need to backfill and compact or grout burrows.					
Inspector Comment

Looking west at the landside slope.

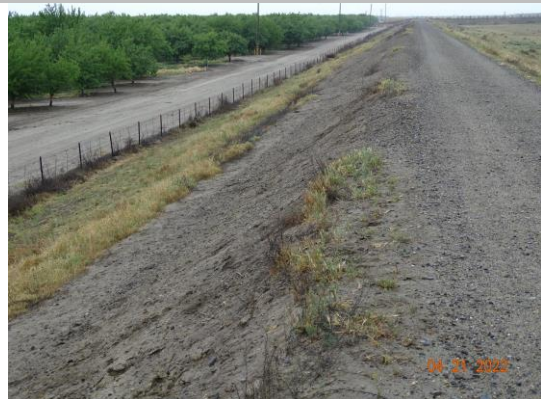
Photo 1 of 1 : SP_2022_NA0010_124_129_20220429_00248.jpg

LM Start	32.37	Rating **	U	Issue No.	129
LM End	32.88	Issue Type +	Ma	Location *	LS
Category	Earthen Levee			GPS Latitude/Longitude	
				Start	End
Item	Erosion / Livestock			37.003251 °	36.997745 °
				-120.421556 °	-120.415197 °
DWR ID	DWR_NA0010_06_s_2022_129				
Comment Code					
E4 : Repair the levee slope damaged by livestock and prevent large animal access.					
Inspector Comment					
Slope damage from livestock. Damage is beginning to erode into levee crown.

Erosion from animal activity along the landside slope. (Spring 2022)

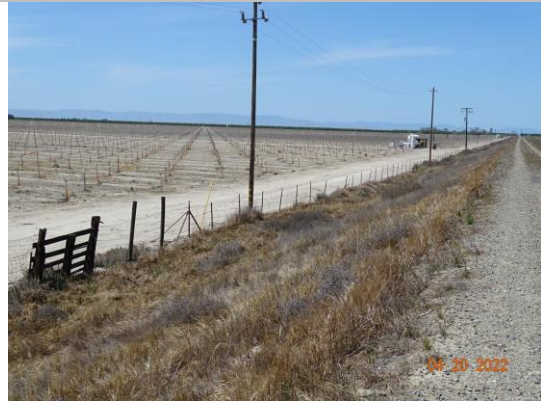
Photo 1 of 1 : SP_2022_NA0010_124_96_20220429_00249.jpg

LM Start	34.62	Rating **	M	Issue No.	96
LM End	36.47	Issue Type +	Ma	Location *	LS
Category	Earthen Levee			GPS Latitude/Longitude	
				Start	End
Item	Vegetation			36.978955 °	36.974155 °
				-120.394385 °	-120.363314 °
DWR ID	DWR_NA0010_06_s_2022_96				
Comment Code					
V1 : Control annual grass and weeds on the levee slopes and easements.					
Inspector Comment

View of the landside slope looking downstream. (Spring 2022)

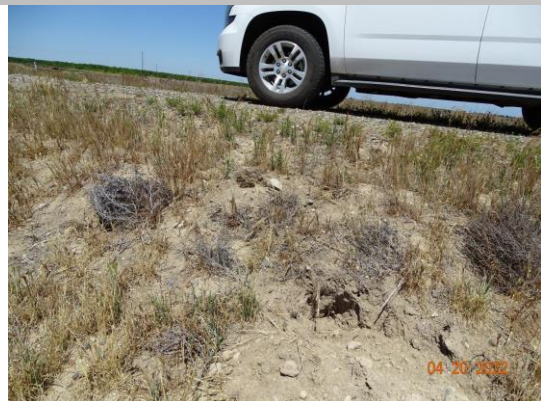
Photo 1 of 1 : SP_2022_NA0010_124_130_20220429_00250.jpg

LM Start	35.51	Rating **	M	Issue No.	130
LM End	35.51	Issue Type +	Ma	Location *	LS
Category	Earthen Levee			GPS Latitude/Longitude	
				Start	End
Item	Animal Control			36.974349 °	36.974349 °
				-120.380584 °	-120.380584 °
DWR ID	DWR_NA0010_06_s_2022_130				
Comment Code					
A3 : No rodents visible, but rodent burrows visible; need to backfill and compact or grout burrows.					
Inspector Comment

Representative view of rodent burrows in the landside slope. (Spring 2022)

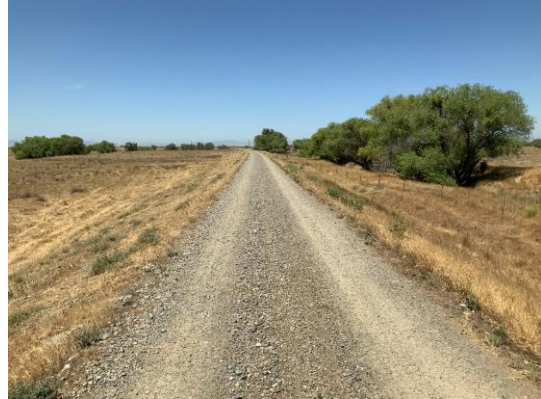
Photo 1 of 3 : UCIP_SP_2022_71165_99437.jpg

Comment Code						
Inspector Comment						
FS_ID:71165 DS_ID:19892 EP_NO: N/A Repair Type: Non-Urgent Crossing Status: Found UCIP Comments: 06/2/2021 Record remains Non-Urgent. DWR DMP internal inspection has not found pipe integrity issues. LOF of crossing is less or equal to 4.0. Recommend next video inspection in 5 years. No permit was found authorizing this encroachment. CVFPB will need to review crossing to determine owner. The UCIP inspection was completed with GEI staff, P. Espinoza. (H. Dunn ? GEI) 07/20/2016 Inlet blocked off by wooden board. Dense vegetation limits the inspector's visibility to identify signs of pipe failure (leaks) along WS and LS. Crossing downgraded from Urgent to Non-Urgent. (O. Magana - DWR UCIP)04/15/2014 Flapgate partially blocked by soil buildup at WS toe. (W. Wylie - DWR UCIP) FIELD_STRUCT_DESC: 24-inch corrugated metal gravity drainage pipe (CMP) through the levee, 10.8 feet below the crown. Flap gate on the waterside (WS) end. Concrete headwall on the landside (LS) end. Concrete U-shaped headwall on the WS end. [Additional Reference(s): DWR Levee Log, 2002, (HLM 0.08). USACE San Joaquin O&M Manual, Unit No. 601, Part No. 1, 1967, Amended in 1978, Revised 20 June 1985, (HLM 0.07). DWR As-Built Specification No. 63-25, Sheet No. 11, 9 May 1963, (HLM 0.07)]. FS Date: 6/2/2021

Levee crown looking downstream.

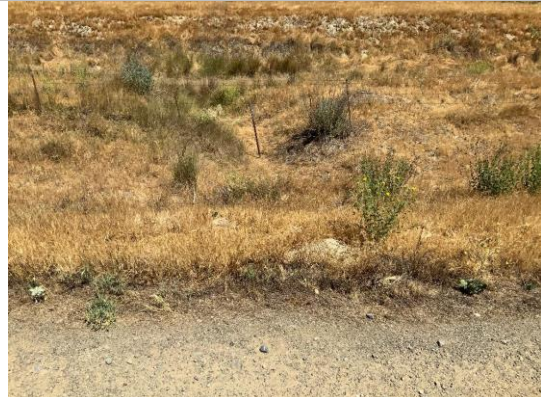
Photo 2 of 3 : UCIP_SP_2022_71165_99440.jpg

LS view: Toe from crown.

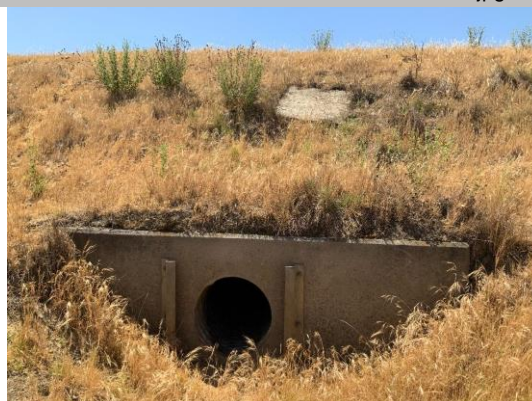
Photo 3 of 3 : UCIP_SP_2022_71165_99441.jpg

LS view: Slope and headwall at toe.

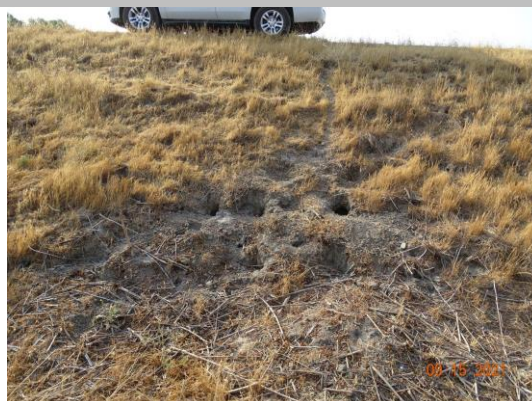
Photo 1 of 1 : SP_2022_NA0010_125_17_20220308_00005.jpg

LM Start	0.10	Rating **	M	Issue No.	17
LM End	0.10	Issue Type +	Ma	Location *	LS
Category	Earthen Levee			GPS Latitude/Longitude	
				Start	End
Item	Animal Control			37.256017 °	37.256017 °
				-120.770636 °	-120.770636 °
DWR ID	DWR_NA0010_07_f_2021_17				
Comment Code					
A3 : No rodents visible, but rodent burrows visible; need to backfill and compact or grout burrows.					
Inspector Comment

View of rodent holes in the landside slope. (Fall 2021)

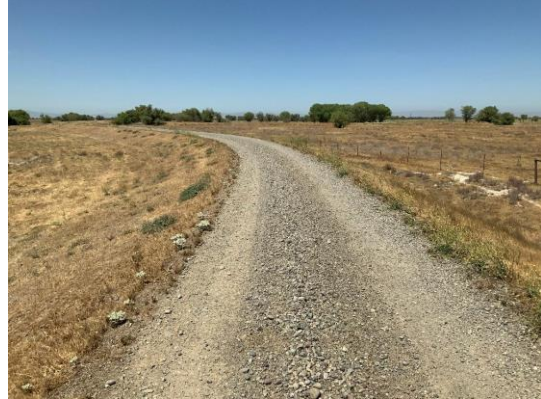
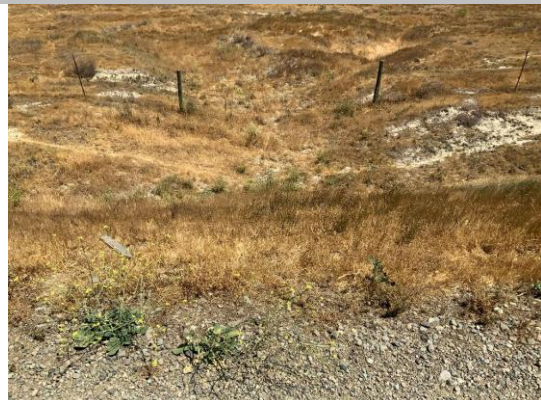
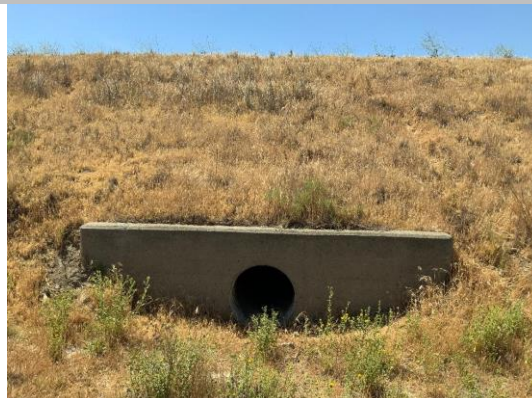
Photo 1 of 3 : UCIP_SP_2022_71166_99444.jpg

Comment Code						
Inspector Comment						
FS_ID:71166 DS_ID:19893 EP_NO: N/A Repair Type: Non-Urgent Crossing Status: Found UCIP Comments: 06/2/2021 The record has been upgraded from No Action Needed to Non-Urgent. DWR DMP internal inspection has not found pipe integrity issues. LOF of crossing is less or equal to 4.0. Recommend next video inspection in 5 years. No permit was found authorizing this encroachment. CVFPB will need to review crossing to determine owner. The UCIP inspection was completed with GEI staff, P. Espinoza. (H. Dunn ? GEI) FIELD_STRUCT_DESC: 24-inch corrugated metal gravity drainage pipe (CMP) through the levee, 11.1 feet below the crown. Flap gate on the waterside (WS) end. Concrete headwall on the landside (LS) end. Concrete U-shaped headwall on the WS end. [Additional Reference(s): DWR Levee Log, 2002, (HLM 0.34). USACE San Joaquin O&M Manual, Unit No. 601, Part No. 1, 1967, Amended in 1978, Revised 20 June 1985, (HLM 0.33). DWR As-Built Specification No. 63-25, Sheet No. 11, 9 May 1963, (HLM 0.33)]. FS Date: 6/2/2021

Levee crown looking downstream.

LS view: Toe from crown.

LS view: Slope and headwall at toe.

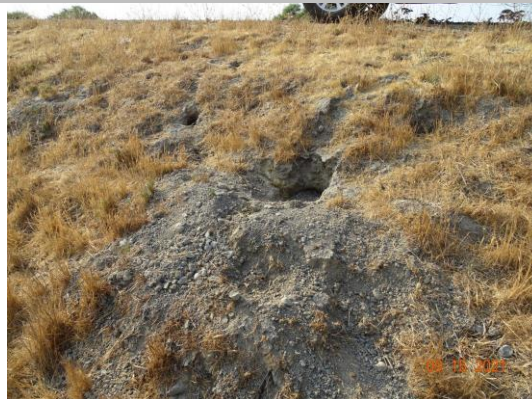
Photo 1 of 1 : SP_2022_NA0010_125_29_20220308_00011.jpg

Several rodent holes were noted on the landside and waterside slope and shoulder.

Looking at representative rodent hole in the landside slope. (Fall 2021)

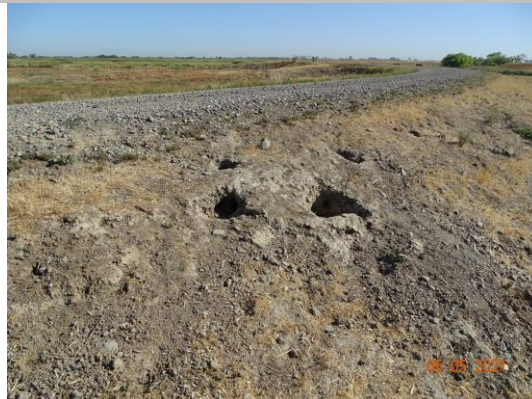
Photo 1 of 1 : SP_2022_NA0010_125_22_20220308_00009.jpg

View of rodent burrows in the waterside slope and shoulder. (Spring 2021)

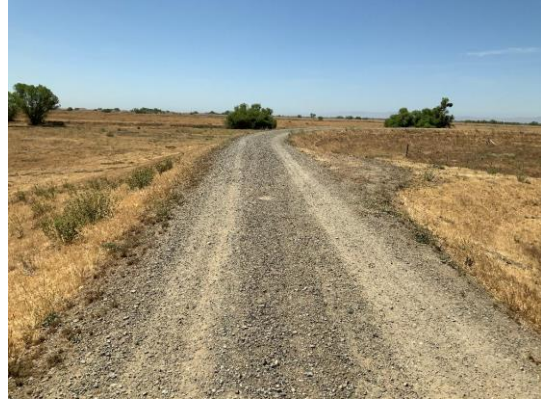
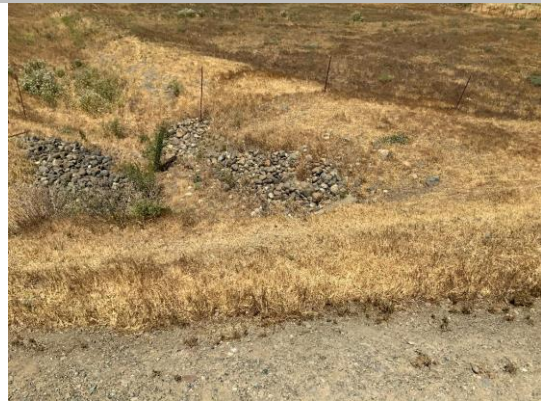
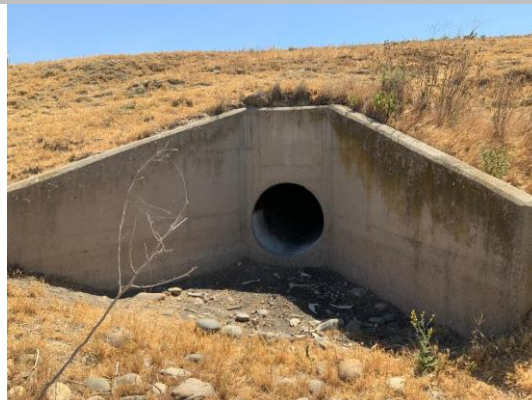
Photo 1 of 3 : UCIP_SP_2022_71167_99452.jpg

Comment Code						
Inspector Comment						
FS_ID:71167 DS_ID:19894 EP_NO: N/A Repair Type: Non-Urgent Crossing Status: Found UCIP Comments: 06/2/2021 Record remains Non-Urgent. No cover over the WS metal riser. There is debris and wood pallets within the riser that may prevent the ability for the slidegate to be opened or water to flow through, recommend cleaning out. DWR DMP internal inspection has not found pipe integrity issues. LOF of crossing is less or equal to 4.0. Recommend next video inspection in 5 years. No permit was found authorizing this encroachment. CVFPB will need to review crossing to determine owner. The UCIP inspection was completed with GEI staff, P. Espinoza. (H. Dunn ? GEI) 04/15/2014 Slide gate not operable, but left in closed position. Need to reinstall covers over slide gate standpipe. (W. Wylie - DWR UCIP) FIELD_STRUCT_DESC: 36-inch corrugated metal gravity drainage pipe (CMP) through the levee, 9.7 feet below the crown. Slide gate in a 48-inch CMP riser unit on the landside (LS) slope. Concrete U-shaped headwall on the LS end. Inlet channel cobble revetted. Dilapidated wooden pier on the waterside (WS). WS slope and outlet ditch cobble revetted. [Additional Reference(s): DWR Levee Log, 2002, (HLM 0.49). USACE San Joaquin O&M Manual, Unit No. 601, Part No. 1, 1967, Amended in 1978, Revised 20 June 1985, (HLM 0.49). DWR As-Built Specification No. 63-25, Sheet No. 11, 9 May 1963, (HLM 0.49)]. FS Date: 6/2/2021

Levee crown looking downstream.

LS view: Toe from crown.

LS view: Slope and headwall at toe.

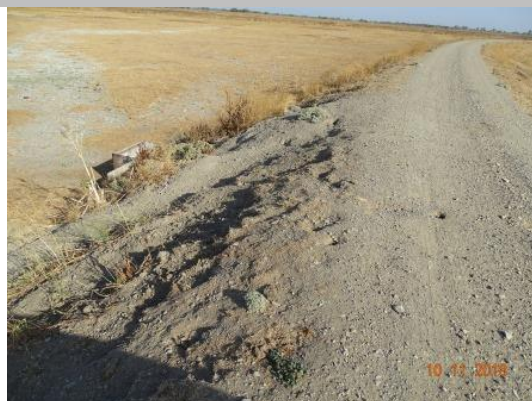
Photo 1 of 1 : SP_2022_NA0010_125_18_20220308_00006.jpg

LM Start	0.53	Rating **	A/W	Issue No.	18
LM End	0.53	Issue Type +	Ma	Location *	LS
Category	Earthen Levee			GPS Latitude/Longitude	
				Start	End
Item	Erosion / Livestock			37.259097 °	37.259097 °
				-120.764846 °	-120.764846 °
DWR ID	DWR_NA0010_07_f_2018_18				
Comment Code					
E4 : Repair the levee slope damaged by livestock and prevent large animal access.					
Inspector Comment					
There is livestock damage to the landside slope.

View of damage from livestock looking upstream. (Fall 2018)

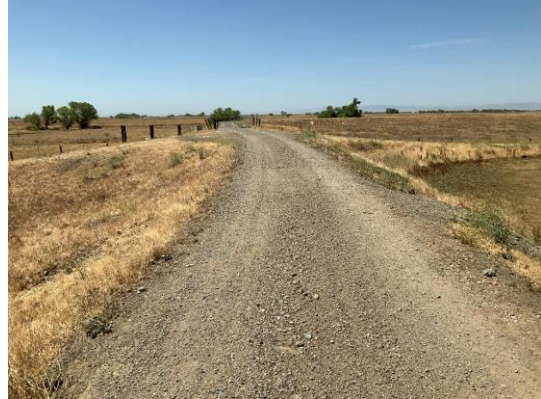
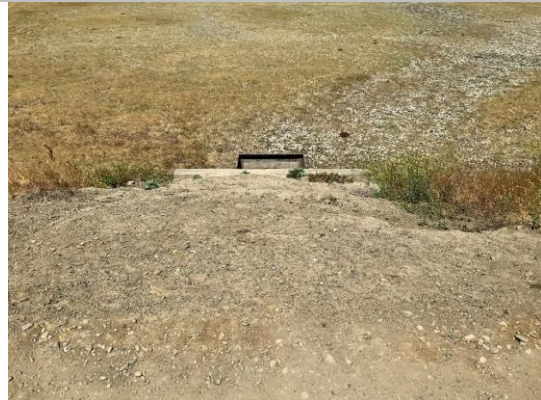
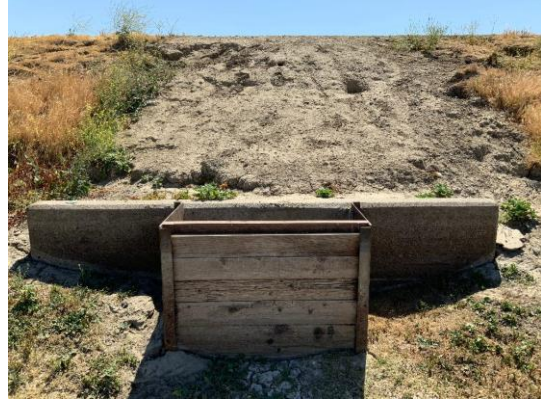
Photo 1 of 3 : UCIP_SP_2022_71168_99460.jpg

Comment Code					
Inspector Comment					
FS_ID:71168 DS_ID:19895 EP_NO: N/A Repair Type: Non-Urgent Crossing Status: Found UCIP Comments: 06/2/2021 The record has been upgraded from No Action Needed to Non-Urgent. DWR DMP internal inspection has not found pipe integrity issues. LOF of crossing is less or equal to 4.0. Recommend next video inspection in 5 years. There are plywood barriers on both WS and LS pipe ends, but no flapgate on either, and flapgate removed on WS. No permit was found authorizing this encroachment. CVFPB will need to review crossing to determine owner. The UCIP inspection was completed with GEI staff, P. Espinoza. (H. Dunn ? GEI) FIELD_STRUCT_DESC: 24-inch corrugated metal gravity drainage pipe (CMP) through the levee, 9.0 feet below the crown. Flap gate on the waterside (WS) end. Concrete headwall with a wooden weir at the inlet on the landside (LS) toe. Concrete U-shaped headwall on the WS toe. [Additional Reference(s): DWR Levee Log, 2002, (HLM 0.53). USACE San Joaquin O&M Manual, Unit No. 601, Part No. 1, 1967, Amended in 1978, Revised 20 June 1985, (HLM 0.53). DWR As-Built Specification No. 63-25, Sheet No. 11, 9 May 1963, (HLM 0.53)]. FS Date: 6/2/2021

Levee crown looking downstream.

LS view: Headwall visible at toe from crown.

LS view: Slope and headwall at toe.

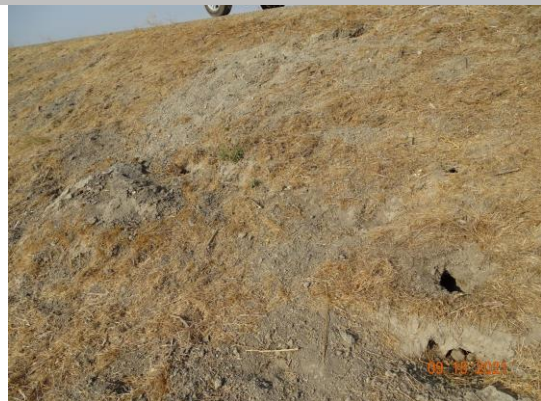
Photo 1 of 1 : SP_2022_NA0010_125_23_20220308_00010.jpg

LM Start	0.56	Rating **	M	Issue No.	23
LM End	0.56	Issue Type +	Ma	Location *	WS
Category	Earthen Levee			GPS Latitude/Longitude	
				Start	End
Item	Animal Control			37.259579 °	37.259579 °
				-120.764687 °	-120.764687 °
DWR ID	DWR_NA0010_07_f_2021_23				
Comment Code					
A1 : Exterminate rodents and backfill and compact or grout burrows.					
Inspector Comment

Looking at rodent burrows along the waterside slope. (Fall 2021)

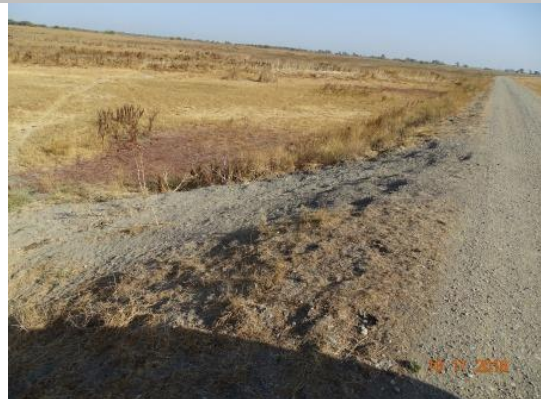
Photo 1 of 1 : SP_2022_NA0010_125_19_20220308_00007.jpg

LM Start	0.70	Rating **	A/W	Issue No.	19
LM End	0.70	Issue Type +	Ma	Location *	LS
Category	Earthen Levee			GPS Latitude/Longitude	
				Start	End
Item	Erosion / Livestock			37.261337 °	37.261337 °
				-120.763303 °	-120.763303 °
DWR ID	DWR_NA0010_07_f_2018_19				
Comment Code					
E4 : Repair the levee slope damaged by livestock and prevent large animal access.					
Inspector Comment					
There is livestock damage to the landside slope.

Damage to landside slope from livestock. (Fall 2018)

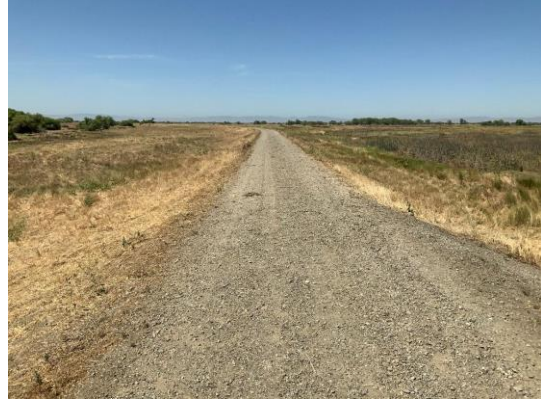
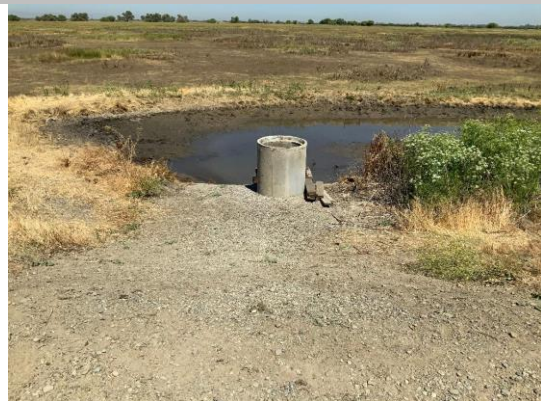
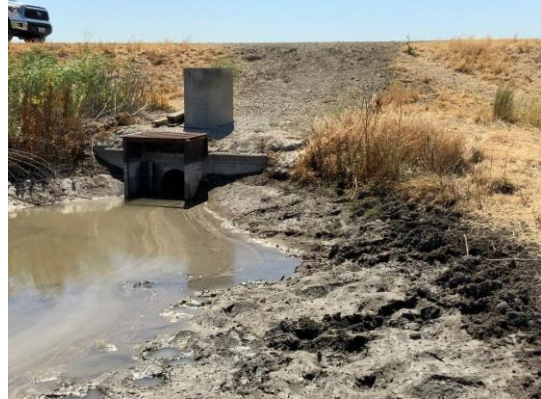
Photo 1 of 3 : UCIP_SP_2022_71169_99467.jpg

Comment Code						
Inspector Comment						
FS_ID:71169 DS_ID:19896 EP_NO: N/A Repair Type: Non-Urgent Crossing Status: Found UCIP Comments: 06/2/2021 Record remains Non-Urgent. No permit was found authorizing this encroachment. CVFPB will need to review crossing to determine owner. Limited inspection due to water flowing through the pipe during inspection. At the time of inspection, the wooden flashboards were not in place on the LS end. The UCIP inspection was completed with GEI staff, P. Espinoza. (H. Dunn ? GEI) 04/15/2014 Need to contact owner. Heavy sediment buildup at inlet due to animal activity should be cleared. (W. Wylie - DWR UCIP) FIELD_STRUCT_DESC: 24-inch corrugated metal gravity drainage pipe (CMP) through the levee, 9.8 feet below the crown. Flap gate on the waterside (WS) end. Wooden weir on a concrete headwall at the landside (LS) toe. 36-inch concrete riser unit at the LS toe. Concrete U-shaped headwall on the WS end. Concrete standpipe on the LS. [Additional Reference(s): DWR Levee Log, 2002, (HLM 0.86). USACE San Joaquin O&M Manual, Unit No. 601, Part No. 1, 1967, Amended in 1978, Revised 20 June 1985, (HLM 0.85). DWR As-Built Specification No. 63-25, Sheet No. 11, 9 May 1963, (HLM 0.85)]. FS Date: 6/2/2021

Levee crown looking downstream.

LS view: Riser visible at toe from crown.

LS view: Slope and riser visible at toe.

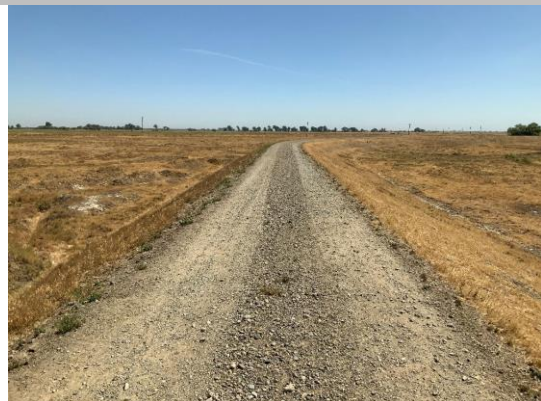
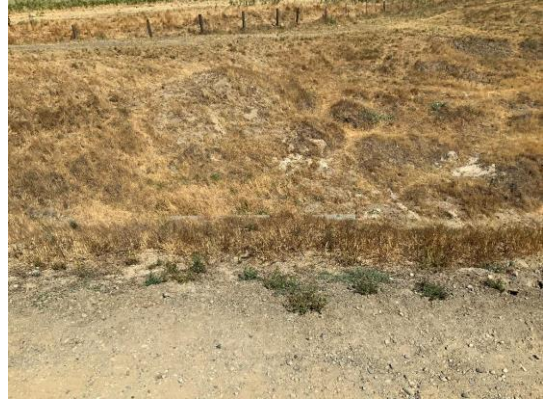
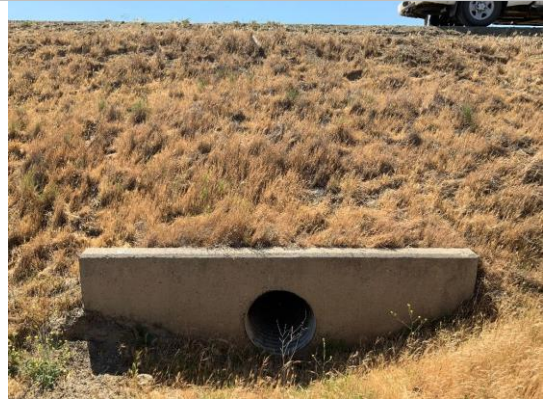
Photo 1 of 3 : UCIP_SP_2022_71170_99474.jpg

FS_ID:71170
DS_ID:19897
EP_NO: N/A
Repair Type: Non-Urgent
Crossing Status: Found
UCIP Comments: 06/2/2021 The record has been upgraded from No Action Needed to Non-Urgent. DWR DMP internal inspection has not found pipe integrity issues. LOF of crossing is less or equal to 4.0. Recommend next video inspection in 5 years. No permit was found authorizing this encroachment. CVFPB will need to review crossing to determine owner. The UCIP inspection was completed with GEI staff, P. Espinoza. (H. Dunn ? GEI)
FIELD_STRUCT_DESC: 24-inch corrugated metal gravity drainage pipe (CMP) through the levee, 11.5 feet below the crown. Flap gate on the waterside (WS) end. Concrete headwall on the landside (LS) end. Concrete U-shaped headwall on the WS end. [Additional Reference(s): DWR Levee Log, 2002, (HLM 0.94). USACE San Joaquin O&M Manual, Unit No. 601, Part No. 1, 1967, Amended in 1978, Revised 20 June 1985, (HLM 0.94). DWR As-Built Specification No. 63-25, Sheet No. 11, 9 May 1963, (HLM 0.94)].

Levee crown looking downstream.

LS view: Toe from crown.

LS view: Slope and headwall at toe.
