**Flood Control Project Maintenance
Levee Inspections**

Maintenance Issue Types Only, Levee Inspection Report By Mile - Spring 2022

Lower San Joaquin Levee District

Waterway	Bank	Unit Miles	Inspection Start/End	Inspector
Unit No. 01 San Joaquin River	Right	22.52	04/05/2022 04/05/2022	Corey Fujitani

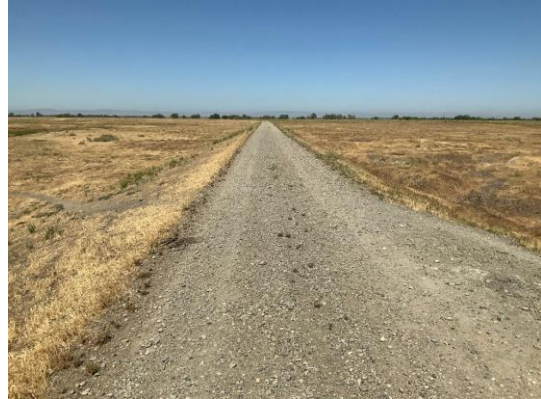
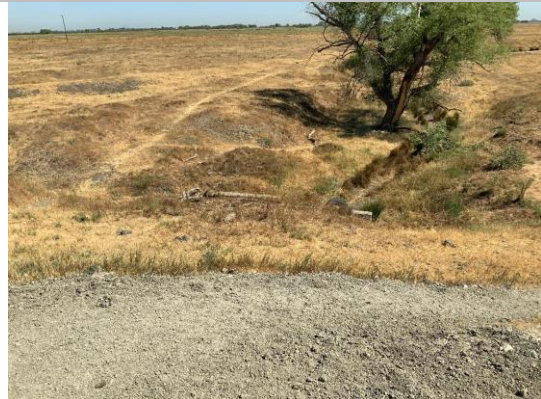
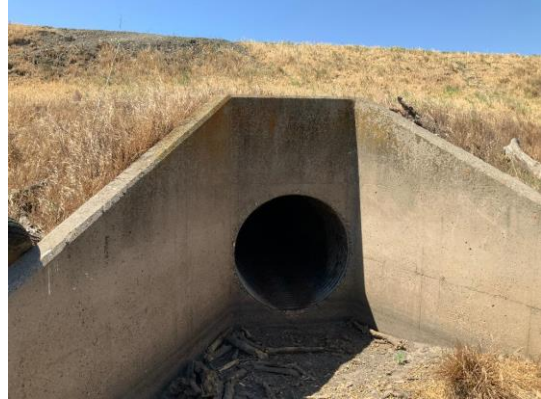
Photo 1 of 3 : UCIP_SP_2022_71171_99481.jpg

Comment Code					
Inspector Comment					
FS_ID:71171 DS_ID:19898 EP_NO: N/A Repair Type: Non-Urgent Crossing Status: Found UCIP Comments: 06/2/2021 The record has been upgraded from No Action Needed to Non-Urgent. No permit was found authorizing this encroachment. CVFPB will need to review crossing to determine owner. The UCIP inspection was completed with GEI staff, P. Espinoza. (H. Dunn ? GEI) FIELD_STRUCT_DESC: 48-inch corrugated metal gravity drainage pipe (CMP) through the levee, 14.6 feet below the crown. Flap gate on the waterside (WS) end. Concrete U-shaped headwall on each end. [Additional Reference(s): DWR Levee Log, 2002, (HLM 1.17). USACE San Joaquin O&M Manual, Unit No. 601, Part No. 1, 1967, Amended in 1978, Revised 20 June 1985, (HLM 1.17). DWR As-Built Specification No. 63-25, Sheet No. 11, 9 May 1963, (HLM 1.17)]. FS Date: 6/2/2021

Levee crown looking downstream.

LS view: Toe from crown.

LS view: Slope and headwall at toe.

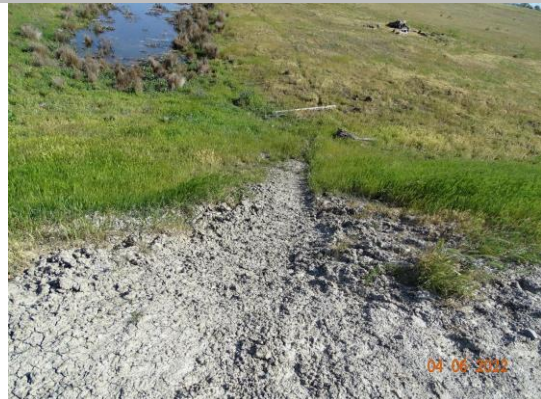
Photo 1 of 1 : SP_2022_NA0010_125_25_20220414_00045.jpg

LM Start	1.24	Rating **	A/W	Issue No.	25	
LM End	1.24	Issue Type +	Ma	Location *	LS	
Category	Earthen Levee			GPS Latitude/Longitude		
				Start		End
Item	Erosion / Livestock			37.264365 °		37.264365 °
				-120.755358 °		-120.755358 °
DWR ID	DWR_NA0010_07_s_2022_25					
Comment Code						
E4 : Repair the levee slope damaged by livestock and prevent large animal access.						
Inspector Comment

Looking down the landside slope at erosion from livestock traffic. (Spring 2022)

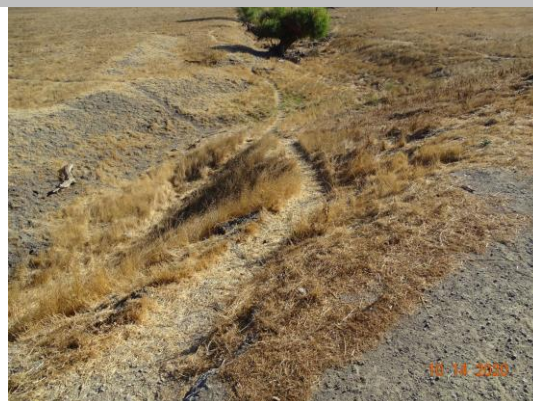
Photo 1 of 1 : SP_2022_NA0010_125_16_20220308_00004.jpg

LM Start	1.49	Rating **	A/W	Issue No.	16
LM End	1.49	Issue Type +	Ma	Location *	LS
Category	Earthen Levee			GPS Latitude/Longitude	
				Start	End
Item	Erosion / Livestock			37.263999 °	37.263999 °
				-120.750854 °	-120.750854 °
DWR ID	DWR_NA0010_07_f_2017_16				
Comment Code					
E4 : Repair the levee slope damaged by livestock and prevent large animal access.					
Inspector Comment					
Monitor the slope damaged by animal traffic.

Cattle trail on the landside slope. (Fall 2020)

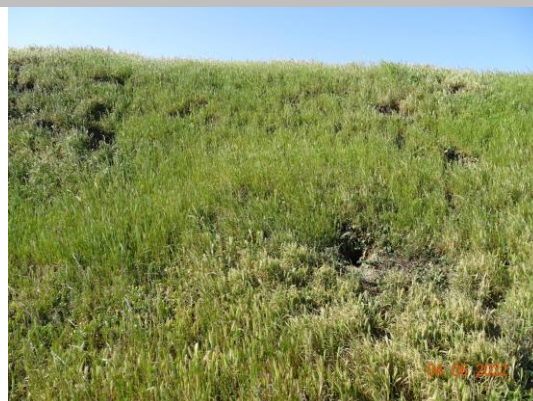
Photo 1 of 1 : SP_2022_NA0010_125_6_20220414_00046.jpg

LM Start	1.50	Rating **	M	Issue No.	6
LM End	1.51	Issue Type +	Ma	Location *	LS
Category	Earthen Levee			GPS Latitude/Longitude	
				Start	End
Item	Animal Control			37.263955 °	37.263885 °
				-120.750751 °	-120.750527 °
DWR ID	DWR_NA0010_07_s_2014_6				
Comment Code					
A1 : Exterminate rodents and backfill and compact or grout burrows.					
Inspector Comment

View of rodent holes on the landside slope. (Spring 2022)

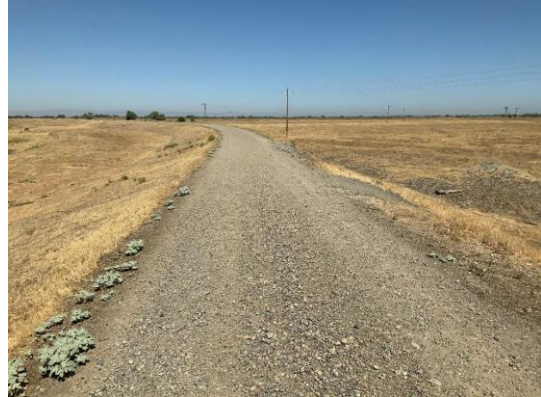
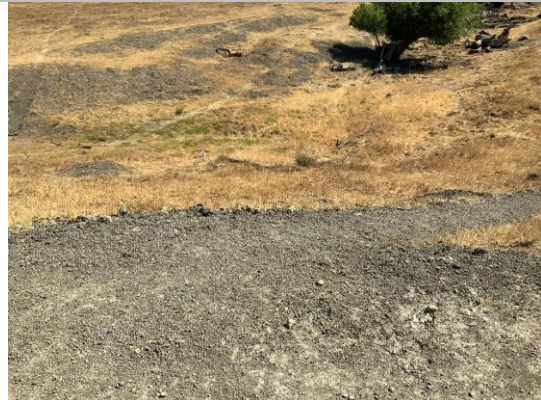
Photo 1 of 3 : UCIP_SP_2022_71172_99488.jpg

Comment Code						
Inspector Comment						
FS_ID:71172 DS_ID:19902 EP_NO: N/A Repair Type: Non-Urgent Crossing Status: Found UCIP Comments: 06/2/2021 The record has been upgraded from No Action Needed to Non-Urgent. DWR DMP internal inspection has not found pipe integrity issues. LOF of crossing is less or equal to 4.0. Recommend next video inspection in 5 years. No permit was found authorizing this encroachment. CVFPB will need to review crossing to determine owner. The UCIP inspection was completed with GEI staff, P. Espinoza. (H. Dunn ? GEI) FIELD_STRUCT_DESC: 24-inch corrugated metal gravity drainage pipe (CMP) through the levee, 14.0 feet below the crown. Flap gate on the waterside (WS) end. Concrete U-shaped headwall on each end. [Additional Reference(s): DWR Levee Log, 2002, (HLM 1.51). USACE San Joaquin O&M Manual, Unit No. 601, Part No. 1, 1967, Amended in 1978, Revised 20 June 1985, (HLM 1.51). DWR As-Built Specification No. 63-25, Sheet No. 12, 9 May 1963, (HLM 1.51)]. FS Date: 6/2/2021

Levee crown looking downstream.

LS view: Toe from crown.

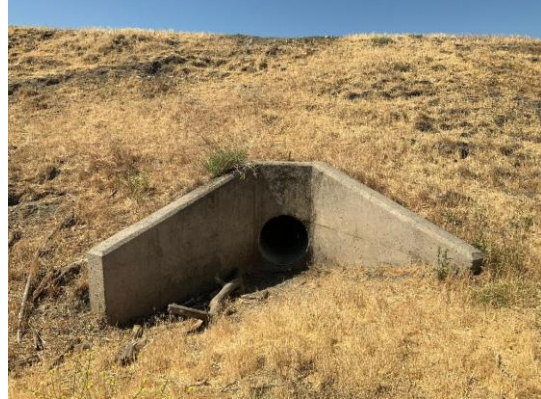
Photo 3 of 3 : UCIP_SP_2022_71172_99486.jpg

LM Start	1.50	Rating **	M	Issue No.	11 (cont)
LM End	1.50	Issue Type +	Ma	Location *	
Category	Supplemental			GPS Latitude/Longitude	
				Start	End
Item	DWR UCIP LMA Responsibility			37.263917 °	37.263917 °
				-120.750694 °	-120.750694 °
DWR ID	19902

LS view: Slope and headwall at toe.

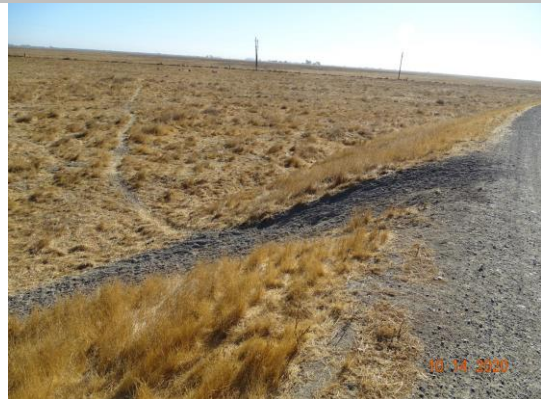
Photo 1 of 1 : SP_2022_NA0010_125_21_20220308_00008.jpg

LM Start	1.90	Rating **	M	Issue No.	21
LM End	1.90	Issue Type +	Ma	Location *	LS
Category	Earthen Levee			GPS Latitude/Longitude	
				Start	End
Item	Erosion / Livestock			37.261379 °	37.261379 °
				-120.744228 °	-120.744228 °
DWR ID	DWR_NA0010_07_f_2018_21				
Comment Code					
E4 : Repair the levee slope damaged by livestock and prevent large animal access.					
Inspector Comment

View of damage to the landside slope. (Fall 2020)

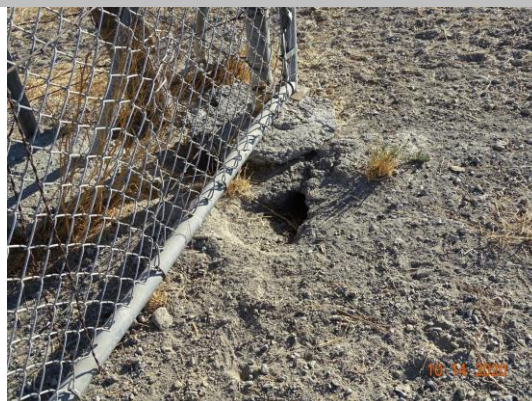
Photo 1 of 1 : SP_2022_NA0010_125_12_20220308_00003.jpg

LM Start	2.09	Rating **	M	Issue No.	12
LM End	2.09	Issue Type +	Ma	Location *	LS
Category	Earthen Levee			GPS Latitude/Longitude	
				Start	End
Item	Animal Control			37.259187 °	37.259187 °
				-120.742551 °	-120.742551 °
DWR ID	DWR_NA0010_07_f_2018_12				
Comment Code					
A3 : No rodents visible, but rodent burrows visible; need to backfill and compact or grout burrows.					
Inspector Comment					
Rodent activity is noted next to the fence post.

View of rodent hole at the fence post on the landside shoulder. (Fall 2020)

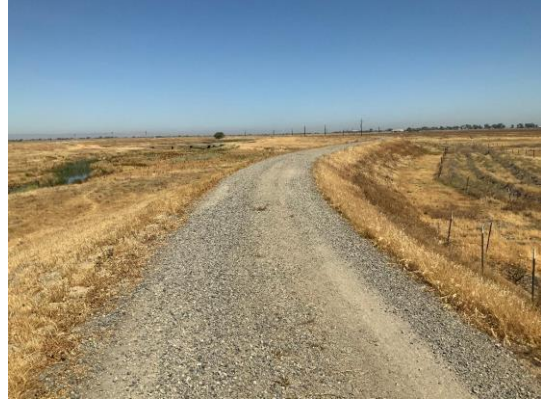
Photo 1 of 3 : UCIP_SP_2022_71173_99497.jpg

Comment Code					
Inspector Comment					
FS_ID:71173 DS_ID:19899 EP_NO: N/A Repair Type: Non-Urgent Crossing Status: Found UCIP Comments: 06/2/2021 The record has been upgraded from No Action Needed to Non-Urgent. LS pipe end surrounded by barbed wire, could not inspect closely. Metal pipe and plastic riser with flowmeter off the LS toe. DWR DMP internal inspection has not found pipe integrity issues. LOF of crossing is less or equal to 4.0. Recommend next video inspection in 5 years. No permit was found authorizing this encroachment. CVFPB will need to review crossing to determine owner. The UCIP inspection was completed with GEI staff, P. Espinoza. (H. Dunn ? GEI) FIELD_STRUCT_DESC: 24-inch corrugated metal gravity drainage pipe (CMP) through the levee, 9.5 feet below the crown. Flap gate on the waterside (WS) end. Concrete headwall on the landside (LS) end. Concrete U-shaped headwall on the WS end. [Additional Reference(s): DWR Levee Log, 2002, (HLM 2.49). USACE San Joaquin O&M Manual, Unit No. 601, Part No. 1, 1967, Amended in 1978, Revised 20 June 1985, (HLM 2.48). DWR As-Built Specification No. 63-25, Sheet No. 12, 9 May 1963, (HLM 2.48)]. FS Date: 6/2/2021

Levee crown looking downstream.

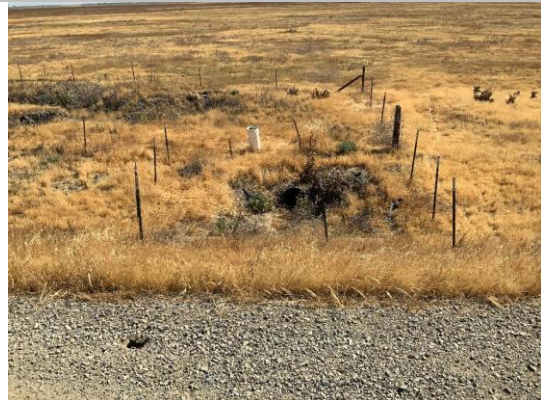
Photo 2 of 3 : UCIP_SP_2022_71173_99498.jpg

LS view: Toe from crown.

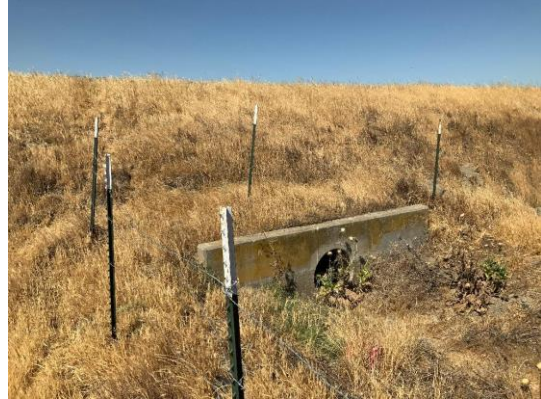
Photo 3 of 3 : UCIP_SP_2022_71173_99499.jpg

LS view: Slope and headwall at toe.

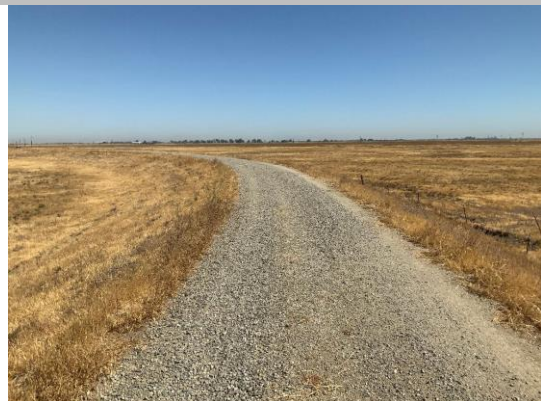
Photo 1 of 3 : UCIP_SP_2022_71174_99504.jpg

FS_ID:71174
DS_ID:19900
EP_NO: N/A
Repair Type: Non-Urgent
Crossing Status: Found
UCIP Comments: 06/2/2021 The record has been upgraded from No Action Needed to Non-Urgent. LS pipe end surrounded by barbed wire, inspection was limited. No permit was found authorizing this encroachment. CVFPB will need to review crossing to determine owner. The UCIP inspection was completed with GEI staff, P. Espinoza. (H. Dunn ? GEI)
FIELD_STRUCT_DESC: 24-inch corrugated metal gravity drainage pipe (CMP) through the levee, 11.5 feet below the crown. Flap gate on the waterside (WS) end. Concrete headwall on the landside (LS) end. Concrete U-shaped headwall on the WS end. [Additional Reference(s): DWR Levee Log, 2002, (HLM 2.65). USACE San Joaquin O&M Manual, Unit No. 601, Part No. 1, 1967, Amended in 1978, Revised 20 June 1985, (HLM 2.64). DWR As-Built Specification No. 63-25, Sheet No. 12, 9 May 1963, (HLM 2.64)].

Levee crown looking downstream.

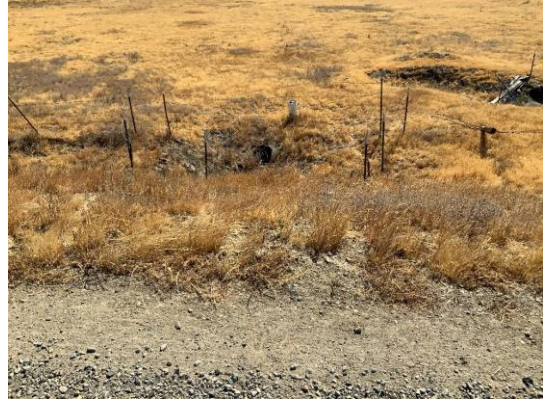
Photo 2 of 3 : UCIP_SP_2022_71174_99501.jpg

LS view: Toe from crown.

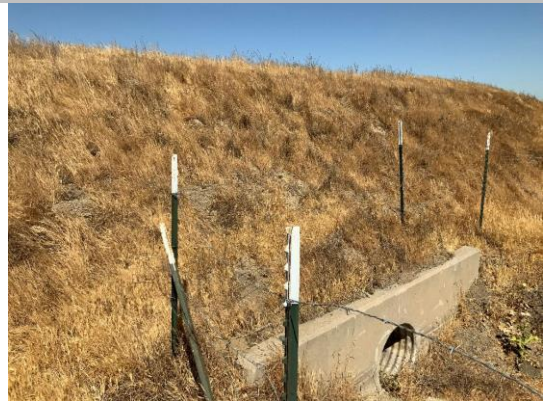
Photo 3 of 3 : UCIP_SP_2022_71174_99502.jpg

LS view: Slope and headwall at toe.

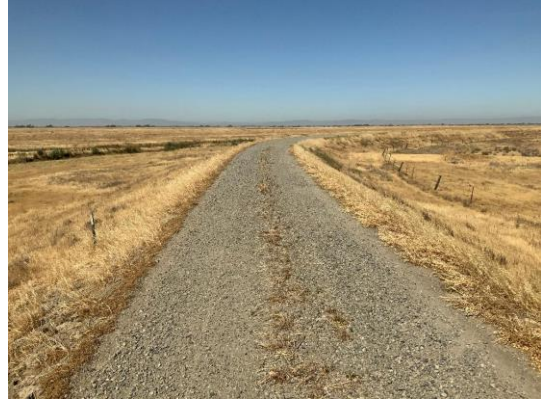
Photo 1 of 3 : UCIP_SP_2022_71175_99510.jpg

Comment Code						
Inspector Comment						
FS_ID:71175 DS_ID:19901 EP_NO: N/A Repair Type: Non-Urgent Crossing Status: Found UCIP Comments: 06/2/2021 Record remains Non-Urgent. DWR DMP internal inspection has found pipe integrity issues. LOF of crossing is equal to 4.1 and less than 5. Crossing will be monitored until funding becomes available for rehabilitation. Some sediment buildup in the inlet of the pipe on the LS, recommend cleaning out. No permit was found authorizing this encroachment. CVFPB will need to review crossing to determine owner. The UCIP inspection was completed with GEI staff, P. Espinoza. (H. Dunn ? GEI) 04/15/2014 Some sediment buildup at landward toe and inside pipe--recommend clearing. (W. Wylie - DWR UCIP) FIELD_STRUCT_DESC: 24-inch corrugated metal gravity drainage pipe (CMP) through the levee, 10.4 feet below the crown. Flap gate on the waterside (WS) end. Concrete headwall on the landside (LS) end. Concrete U-shaped headwall on the WS end. [Additional Reference(s): DWR Levee Log, 2002, (HLM 3.09). USACE San Joaquin O&M Manual, Unit No. 601, Part No. 1, 1967, Amended in 1978, Revised 20 June 1985, (HLM 3.09). DWR As-Built Specification No. 63-25, Sheet No. 13, 9 May 1963, (HLM 3.09)]. FS Date: 6/2/2021

Levee crown looking downstream.

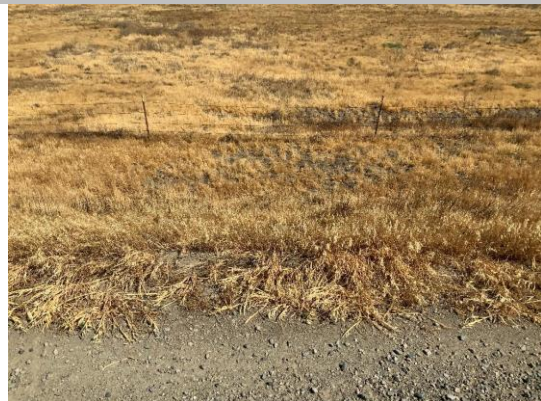
Photo 2 of 3 : UCIP_SP_2022_71175_99512.jpg

LS view: Toe from crown.

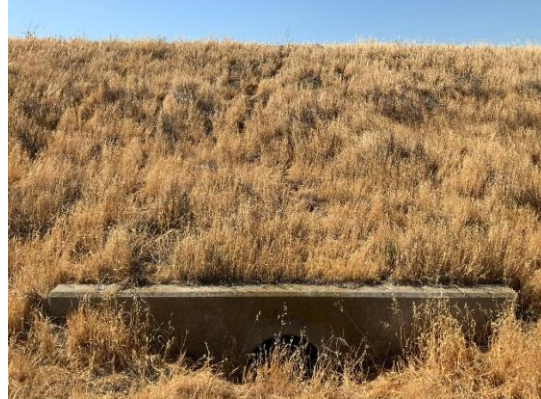
Photo 3 of 3 : UCIP_SP_2022_71175_99513.jpg

LS view: Slope and headwall at toe.

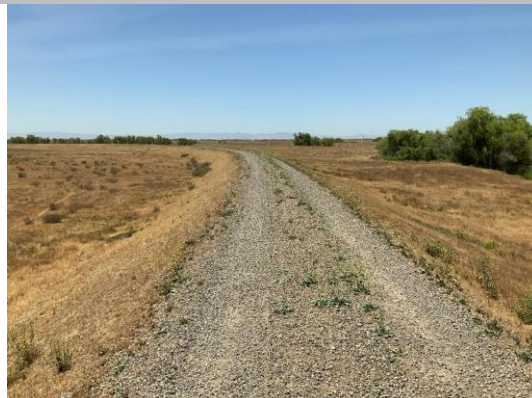
Photo 1 of 3 : UCIP_SP_2022_71177_99546.jpg

Comment Code						
Inspector Comment						
FS_ID:71177 DS_ID:19903 EP_NO: N/A Repair Type: Non-Urgent Crossing Status: Found UCIP Comments: 06/2/2021 The record has been upgraded from No Action Needed to Non-Urgent. DWR DMP internal inspection has not found pipe integrity issues. LOF of crossing is less or equal to 4.0. Recommend next video inspection in 5 years. No permit was found authorizing this encroachment. CVFPB will need to review crossing to determine owner. The UCIP inspection was completed with GEI staff, P. Espinoza. (H. Dunn ? GEI) FIELD_STRUCT_DESC: 24-inch corrugated metal gravity drainage pipe (CMP) through the levee, 9.6 feet below the crown. Flap gate on the waterside (WS) end. Concrete headwall on the landside (LS) end. Concrete U-shaped headwall on the WS end. [Additional Reference(s): DWR Levee Log, 2002, (HLM 0.23). USACE San Joaquin O&M Manual, Unit No. 601, Part No. 1, 1967, Amended in 1978, Revised 20 June 1985, (HLM 0.23). DWR As-Built Specification No. 63-25, Sheet No. 11, 9 May 1963, (HLM 0.23)]. FS Date: 6/2/2021

Levee crown looking downstream.

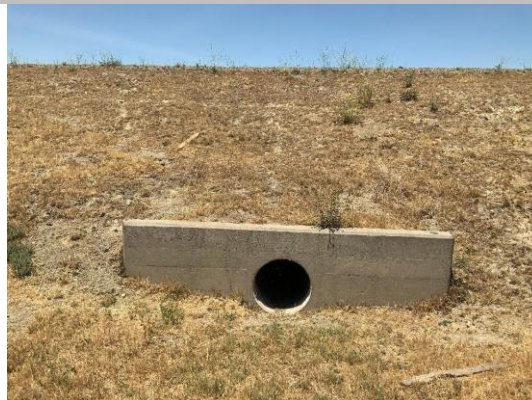
Photo 2 of 3 : UCIP_SP_2022_71177_99547.jpg

LS view: Slope and headwall at toe.

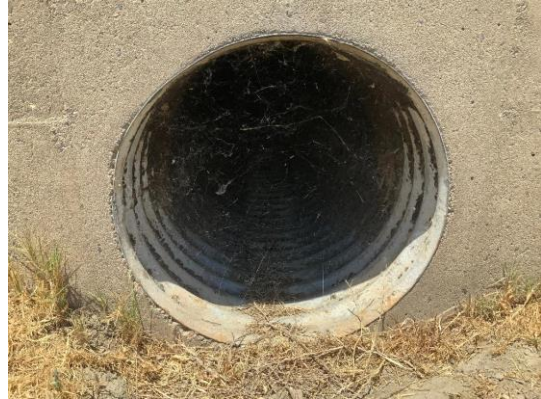
Photo 3 of 3 : UCIP_SP_2022_71177_99548.jpg

LS view: Close up of pipe inlet at toe.

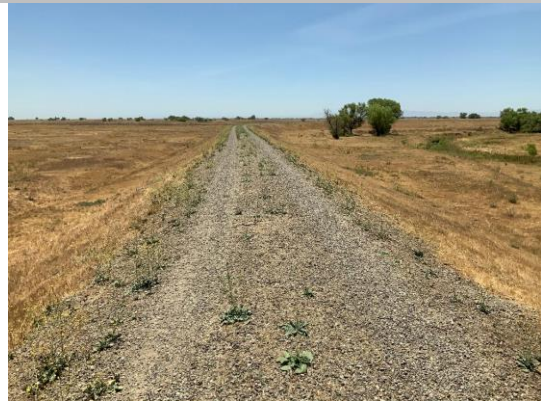
Photo 1 of 3 : UCIP_SP_2022_71178_99553.jpg

FS_ID:71178
DS_ID:19904
EP_NO: N/A
Repair Type: Non-Urgent
Crossing Status: Found
UCIP Comments: 06/2/2021 The record has been upgraded from No Action Needed to Non-Urgent. DWR DMP internal inspection has not found pipe integrity issues. LOF of crossing is less or equal to 4.0. Recommend next video inspection in 5 years. No permit was found authorizing this encroachment. CVFPB will need to review crossing to determine owner. The UCIP inspection was completed with GEI staff, P. Espinoza. (H. Dunn ? GEI)
FIELD_STRUCT_DESC: 24-inch corrugated metal gravity drainage pipe (CMP) through the levee, 12.4 feet below the crown. Flap gate on the waterside (WS) end. Concrete headwall on each end. [Additional Reference(s): DWR Levee Log, 2002, (HLM 0.55). USACE San Joaquin O&M Manual, Unit No. 601, Part No. 1, 1967, Amended in 1978, Revised 20 June 1985, (HLM 0.57). DWR As-Built Specification No. 63-25, Sheet No. 11, 9 May 1963, (HLM 0.57)].

Levee crown looking downstream.

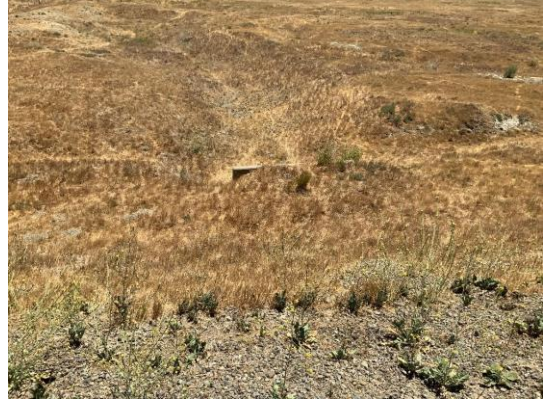
Photo 2 of 3 : UCIP_SP_2022_71178_99554.jpg

LS view: Headwall visible at toe from crown.

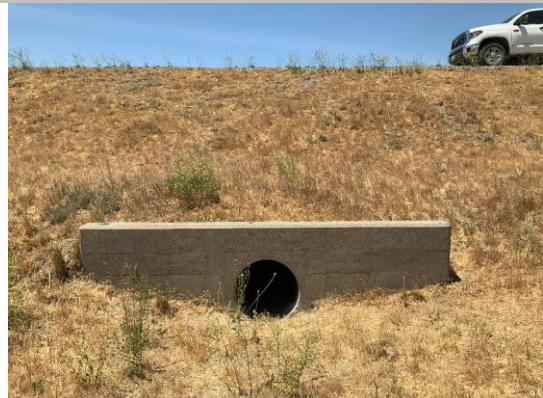
Photo 3 of 3 : UCIP_SP_2022_71178_99555.jpg

LS view: Slope and headwall at toe.

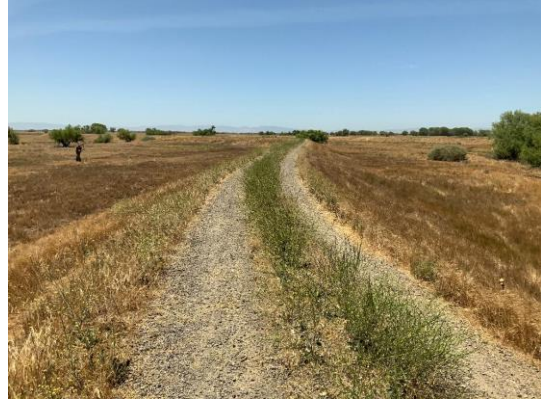
Photo 1 of 3 : UCIP_SP_2022_71179_99560.jpg

Comment Code						
Inspector Comment						
FS_ID:71179 DS_ID:19905 EP_NO: N/A Repair Type: Non-Urgent Crossing Status: Found UCIP Comments: 06/2/2021 The record has been upgraded from No Action Needed to Non-Urgent. DWR DMP internal inspection has not found pipe integrity issues. LOF of crossing is less or equal to 4.0. Recommend next video inspection in 5 years. No permit was found authorizing this encroachment. CVFPB will need to review crossing to determine owner. The UCIP inspection was completed with GEI staff, P. Espinoza. (H. Dunn ? GEI) FIELD_STRUCT_DESC: 24-inch corrugated metal gravity drainage pipe (CMP) through the levee, 10.0 feet below the crown. Flap gate on the waterside (WS) end. Concrete headwall on each end. [Additional Reference(s): DWR Levee Log, 2002, (HLM 0.70). USACE San Joaquin O&M Manual, Unit No. 601, Part No. 1, 1967, Amended in 1978, Revised 20 June 1985, (HLM 0.72). DWR As-Built Specification No. 63-25, Sheet No. 11, 9 May 1963, (HLM 0.72)]. FS Date: 6/2/2021

Levee crown looking downstream.

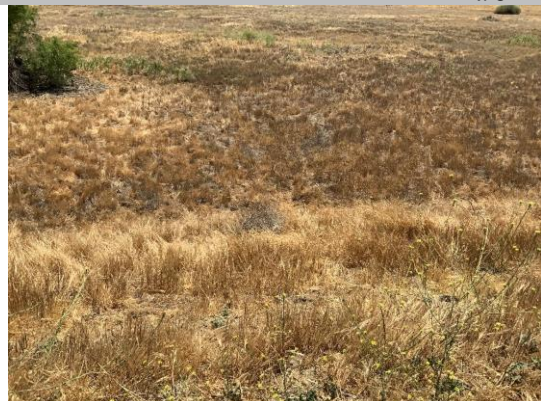
Photo 2 of 3 : UCIP_SP_2022_71179_99561.jpg

LS view: Toe from crown.

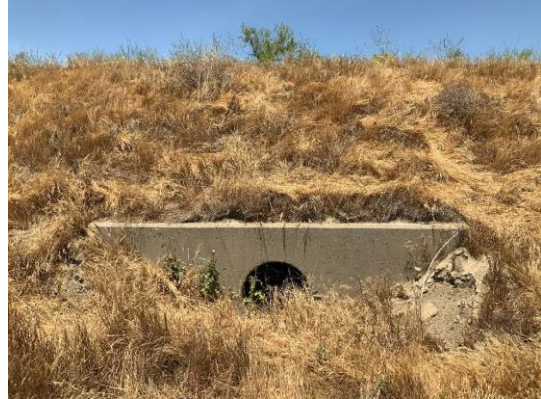
Photo 3 of 3 : UCIP_SP_2022_71179_99562.jpg

LS view: Slope and headwall at toe.

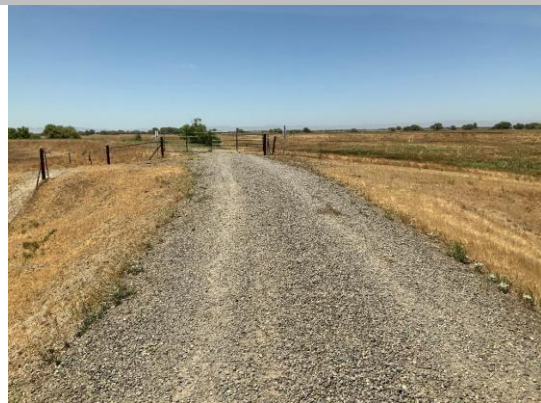
Photo 1 of 3 : UCIP_SP_2022_71180_99567.jpg

FS_ID:71180
DS_ID:19832
EP_NO: N/A
Repair Type: Non-Urgent
Crossing Status: Found
UCIP Comments: 06/2/2021 Record remains Non-Urgent. DWR DMP internal inspection has not found pipe integrity issues. LOF of crossing is less or equal to 4.0. Recommend next video inspection in 5 years. No permit was found authorizing this encroachment. CVFPB will need to review crossing to determine owner. The UCIP inspection was completed with GEI staff, P. Espinoza. (H. Dunn ? GEI) 04/16/2014
Some sediment buildup at inlet on LS toe. (W. Wylie - DWR UCIP)
FIELD_STRUCT_DESC: 24-inch corrugated metal gravity drainage pipe (CMP) through the levee, 11.5 feet below the crown. Flap gate on the waterside (WS) end. Concrete headwall on each end. [Additional Reference(s): DWR Levee Log, 2002, (HLM 0.88). USACE San Joaquin O&M Manual, Unit No. 601, Part No. 1, 1967, Amended in 1978, Revised 20 June 1985, (HLM 0.89). DWR As-Built Specification No. 63-25, Sheet No. 11, 9 May 1963, (HLM 0.89)].

Levee crown looking downstream.

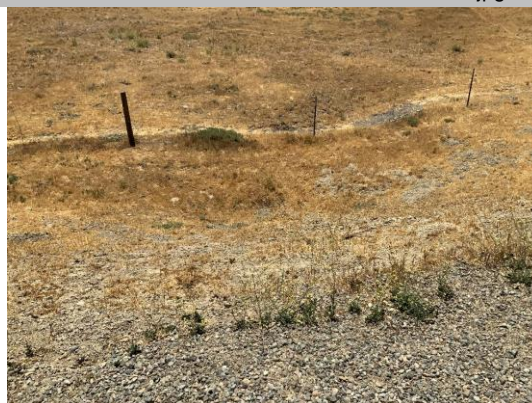
Photo 2 of 3 : UCIP_SP_2022_71180_99568.jpg

LS view: Toe from crown.

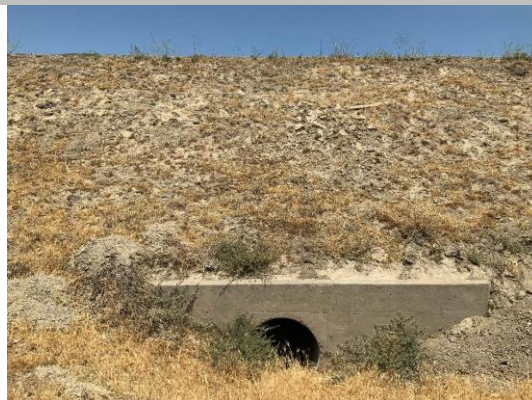
Photo 3 of 3 : UCIP_SP_2022_71180_99569.jpg

LS view: Slope and headwall at toe.

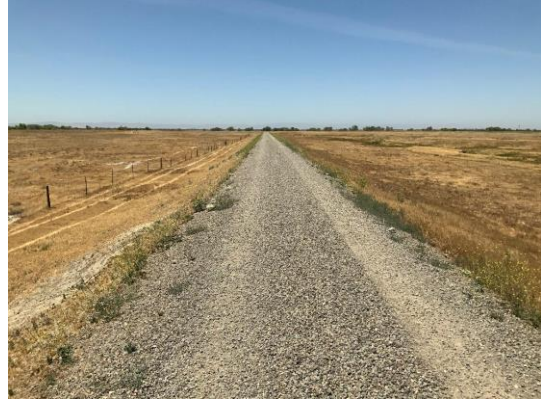
Photo 1 of 3 : UCIP_SP_2022_71181_99573.jpg

Comment Code						
Inspector Comment						
FS_ID:71181 DS_ID:19833 EP_NO: N/A Repair Type: Non-Urgent Crossing Status: Found UCIP Comments: 06/2/2021 Record remains Non-Urgent. Some vegetation in LS pipe inlet, recommend clearing out. DWR DMP internal inspection has not found pipe integrity issues. LOF of crossing is less or equal to 4.0. Recommend next video inspection in 5 years. No permit was found authorizing this encroachment. CVFPB will need to review crossing to determine owner. The UCIP inspection was completed with GEI staff, P. Espinoza. (H. Dunn ? GEI) 04/16/2014 Debris blocking landward headwall--recommend clearing. (W. Wylie - DWR UCIP) FIELD_STRUCT_DESC: 24-inch corrugated metal gravity drainage pipe (CMP) through the levee, 11.6 feet below the crown. Flap gate on the waterside (WS) end. Concrete headwall on each end. [Additional Reference(s): DWR Levee Log, 2002, (HLM 1.20). USACE San Joaquin O&M Manual, Unit No. 601, Part No. 1, 1967, Amended in 1978, Revised 20 June 1985, (HLM 1.21). DWR As-Built Specification No. 63-25, Sheet No. 11, 9 May 1963, (HLM 1.21)]. FS Date: 6/2/2021

Levee crown looking downstream.

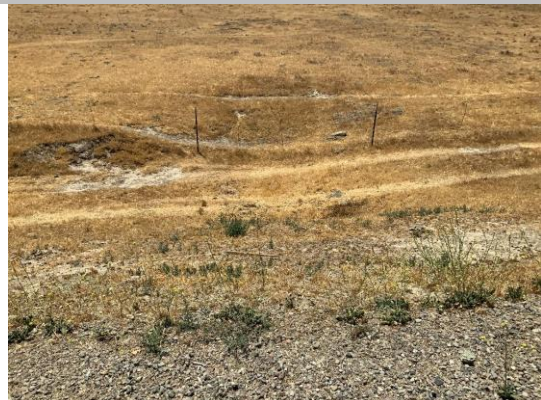
Photo 2 of 3 : UCIP_SP_2022_71181_99574.jpg

LS view: Toe from crown.

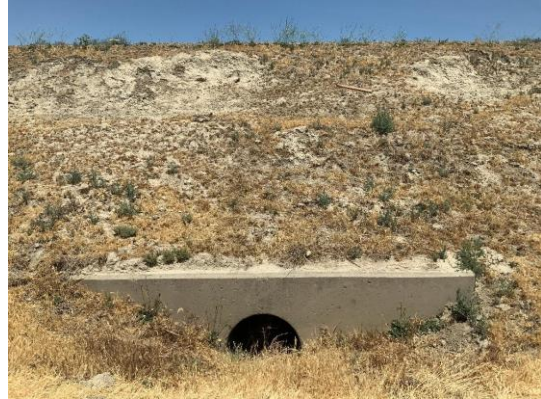
Photo 3 of 3 : UCIP_SP_2022_71181_99575.jpg

LS view: Slope and headwall at toe.

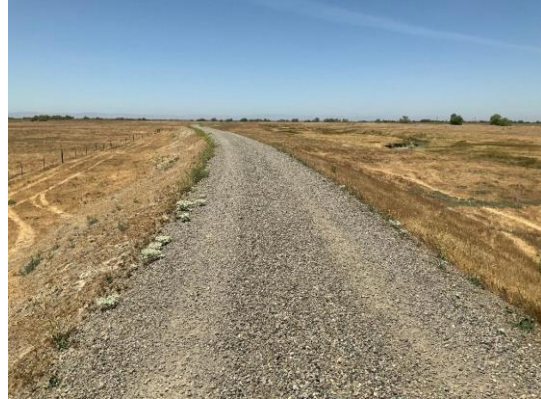
Photo 1 of 3 : UCIP_SP_2022_71182_99581.jpg

Comment Code					
Inspector Comment					
FS_ID:71182 DS_ID:19834 EP_NO: N/A Repair Type: Non-Urgent Crossing Status: Found UCIP Comments: 06/2/2021 Record remains Non-Urgent. Vegetation sticking out of WS flapgate, recommend removal. DWR DMP internal inspection has not found pipe integrity issues. LOF of crossing is less or equal to 4.0. Recommend next video inspection in 5 years. No permit was found authorizing this encroachment. CVFPB will need to review crossing to determine owner. The UCIP inspection was completed with GEI staff, P. Espinoza. (H. Dunn ? GEI) 04/16/2014 Animal burrows along pipe alignment on LS. Some sediment buildup at LS toe and inside pipe--recommend clearing. (W. Wylie -DWR UCIP) FIELD_STRUCT_DESC: 24-inch corrugated metal gravity drainage pipe (CMP) through the levee, 11.5 feet below the crown. Flap gate on the waterside (WS) end. Concrete headwall on each end. [Additional Reference(s): DWR Levee Log, 2002, (HLM 1.37). USACE San Joaquin O&M Manual, Unit No. 601, Part No. 1, 1967, Amended in 1978, Revised 20 June 1985, (HLM 1.38). DWR As-Built Specification No. 63-25, Sheet No. 12, 9 May 1963, (HLM 1.38)]. FS Date: 6/2/2021

Levee crown looking downstream.

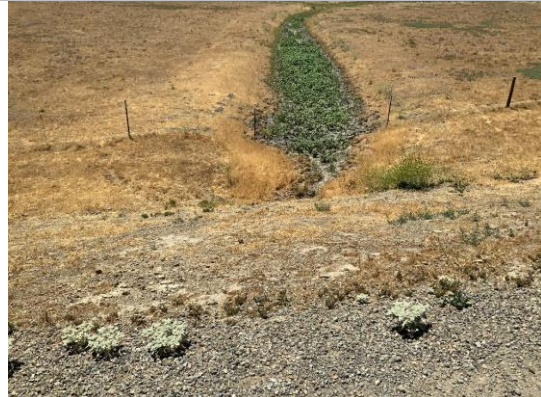
Photo 2 of 3 : UCIP_SP_2022_71182_99582.jpg

LS view: Toe from crown.

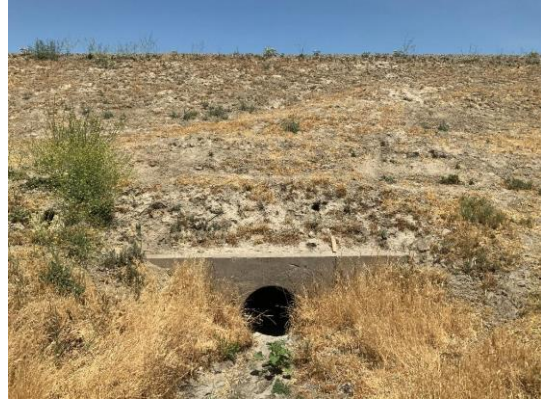
Photo 3 of 3 : UCIP_SP_2022_71182_99583.jpg

LS view: Slope and headwall at toe.

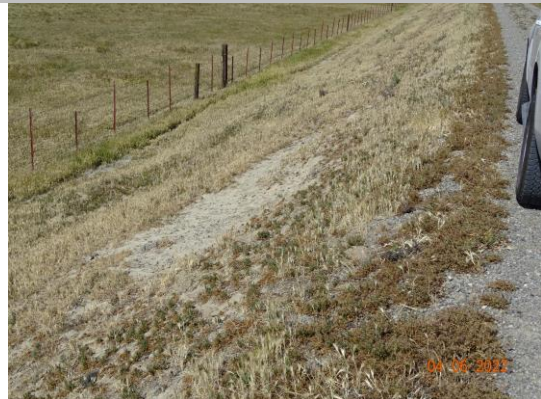
Photo 1 of 1 : SP_2022_NA0010_126_26_20220414_00044.jpg

LM Start	1.81	Rating **	M	Issue No.	26
LM End	1.81	Issue Type +	Ma	Location *	LS
Category	Earthen Levee			GPS Latitude/Longitude	
				Start	End
Item	Erosion / Livestock			37.260673 °	37.260673 °
				-120.745290 °	-120.745290 °
DWR ID	DWR_NA0010_08_f_2019_26				
Comment Code					
E4 : Repair the levee slope damaged by livestock and prevent large animal access.					
Inspector Comment

Looking downstream at erosion spot on the landside slope. (Spring 2022)

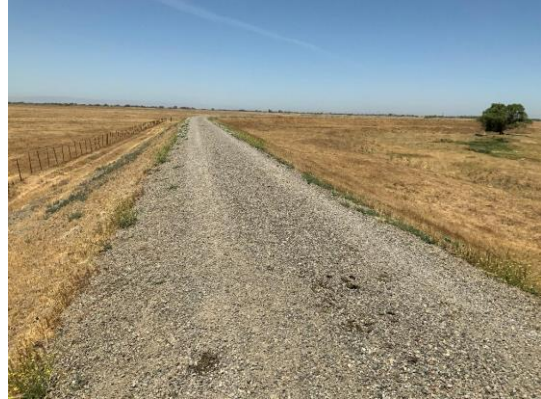
Photo 1 of 3 : UCIP_SP_2022_71183_99586.jpg

Comment Code						
Inspector Comment						
FS_ID:71183 DS_ID:19835 EP_NO: N/A Repair Type: Non-Urgent Crossing Status: Found UCIP Comments: 06/2/2021 Record remains Non-Urgent. LS pipe end not visible at all, appears to be buried or removed. Need to contact owner to determine status of pipe. DWR DMP internal inspection has not found pipe integrity issues. LOF of crossing is less or equal to 4.0. Recommend next video inspection in 5 years. No permit was found authorizing this encroachment. CVFPB will need to review crossing to determine owner. The UCIP inspection was completed with GEI staff, P. Espinoza. (H. Dunn ? GEI) 04/16/2014 Non-functional landward inlet is buried in sediment. Need to contact owner to determine status. (W. Wylie - DWR UCIP) FIELD_STRUCT_DESC: 24-inch corrugated metal gravity drainage pipe (CMP) through the levee, 12.0 feet below the crown. Flap gate on the waterside (WS) end. Concrete headwall on each end. [Additional Reference(s): DWR Levee Log, 2002, (HLM 2.04). USACE San Joaquin O&M Manual, Unit No. 601, Part No. 1, 1967, Amended in 1978, Revised 20 June 1985, (HLM 2.05). DWR As-Built Specification No. 63-25, Sheet No. 12, 9 May 1963, (HLM 2.05)]. FS Date: 6/2/2021

Levee crown looking downstream.

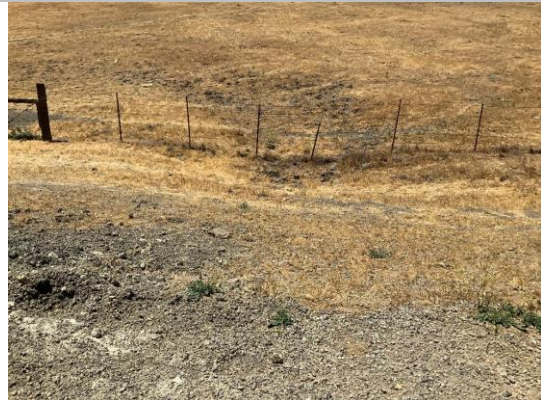
Photo 2 of 3 : UCIP_SP_2022_71183_99587.jpg

LS view: Toe from crown, no pipe visible.

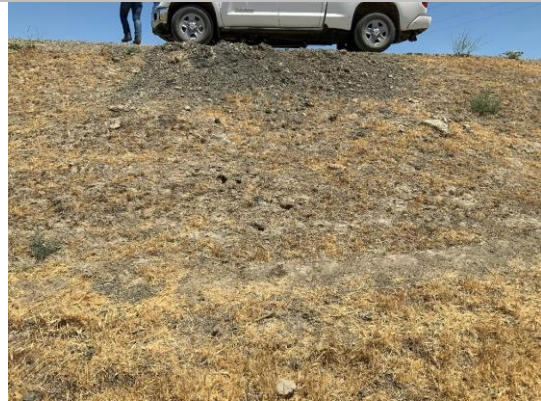
Photo 3 of 3 : UCIP_SP_2022_71183_99588.jpg

LS view: Slope from toe, no pipe visible.

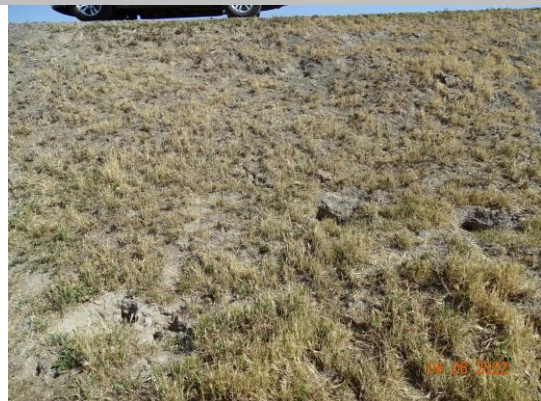
Photo 1 of 1 : SP_2022_NA0010_126_25_20220414_00045.jpg

LM Start	2.07	Rating **	M	Issue No.	25
LM End	2.07	Issue Type +	Ma	Location *	LS
Category	Earthen Levee			GPS Latitude/Longitude	
				Start	End
Item	Animal Control			37.258059 °	37.258059 °
				-120.742451 °	-120.742451 °
DWR ID	DWR_NA0010_08_f _ 2019_25				
Comment Code					
A1 : Exterminate rodents and backfill and compact or grout burrows.					
Inspector Comment

Looking uphill at rodent holes in the landside slope. (Spring 2022)

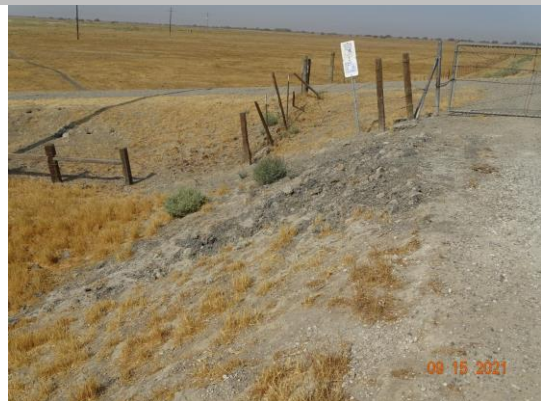
Photo 1 of 1 : SP_2022_NA0010_126_22_20220308_00005.jpg

LM Start	2.07	Rating **	A/W	Issue No.	22
LM End	2.07	Issue Type +	Ma	Location *	LS
Category	Earthen Levee			GPS Latitude/Longitude	
				Start	End
Item	Erosion / Livestock			37.258076 °	37.258076 °
				-120.742439 °	-120.742439 °
DWR ID	DWR_NA0010_08_f_2018_22				
Comment Code					
E4 : Repair the levee slope damaged by livestock and prevent large animal access.					
Inspector Comment					
Erosion from livestock has been repaired. Monitor for settlement.

Repaired slope damage should be monitored for settlement. (Fall 2021)

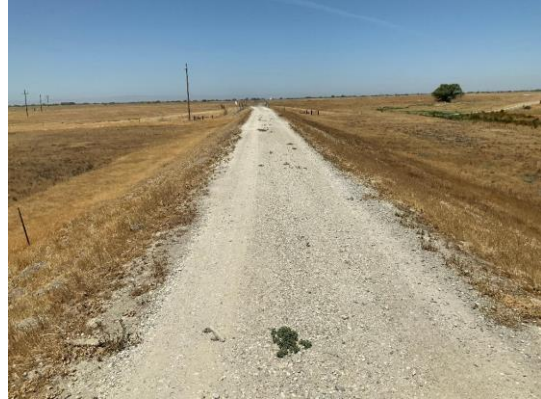
Photo 1 of 3 : UCIP_SP_2022_71184_99597.jpg

Comment Code					
Inspector Comment					
FS_ID:71184 DS_ID:19836 EP_NO: N/A Repair Type: Non-Urgent Crossing Status: Found UCIP Comments: 06/2/2021 The record remains Non-Urgent. DWR DMP internal inspection has not found pipe integrity issues. LOF of crossing is less or equal to 4.0. Recommend next video inspection in 5 years. New 6 inch plastic riser with flowmeter and 24 inch metal pipe underground off the LS toe, directly opposite of the LS pipe inlet of this DSID. No permit was found authorizing this encroachment. CVFPB will need to review crossing to determine owner. The UCIP inspection was completed with GEI staff, P. Espinoza. (H. Dunn ? GEI) 04/16/2014 Sediment buildup in pipe visible from landward side. (W. Wylie - DWR UCIP) FIELD_STRUCT_DESC: 24-inch corrugated metal gravity drainage pipe (CMP) through the levee, 9.5 feet below the crown. Flap gate on the waterside (WS) end. Concrete headwall on each end. [Additional Reference(s): DWR Levee Log, 2002, (HLM 2.12). USACE San Joaquin O&M Manual, Unit No. 601, Part No. 1, 1967, Amended in 1978, Revised 20 June 1985, (HLM 2.12). DWR As-Built Specification No. 63-25, Sheet No. 12, 9 May 1963, (HLM 2.12)]. FS Date: 6/2/2021

Levee crown looking downstream.

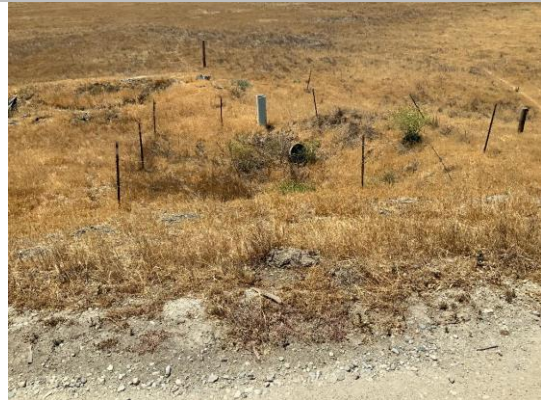
Photo 2 of 3 : UCIP_SP_2022_71184_99599.jpg

LS view: Toe from crown.

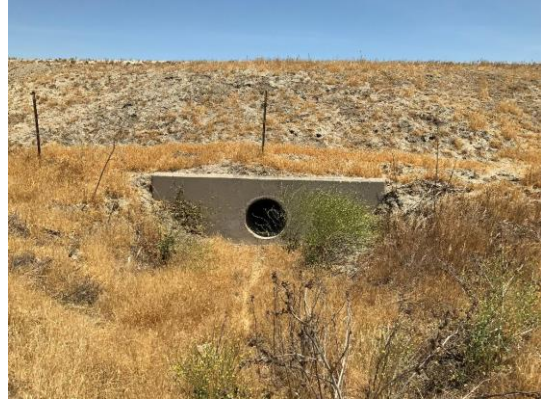
Photo 3 of 3 : UCIP_SP_2022_71184_99600.jpg

LS view: Slope and headwall at toe.

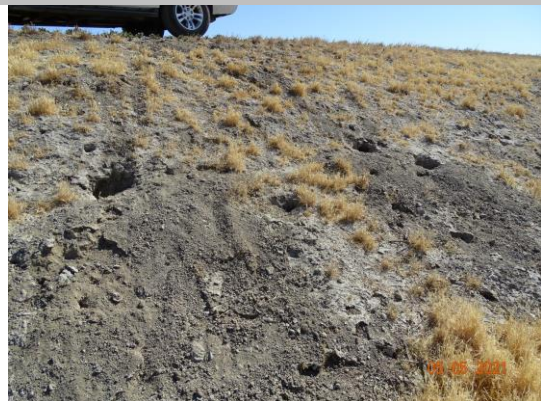
Photo 1 of 1 : SP_2022_NA0010_126_18_20220308_00003.jpg

LM Start	2.29	Rating **	M	Issue No.	18
LM End	2.43	Issue Type +	Ma	Location *	LS
Category	Earthen Levee			GPS Latitude/Longitude	
				Start	End
Item	Animal Control			37.256251 °	37.254767 °
				-120.739280 °	-120.737772 °
DWR ID	DWR_NA0010_08_s_2021_18				
Comment Code					
A1 : Exterminate rodents and backfill and compact or grout burrows.					
Inspector Comment

View of rodent holes in the landside slope. (Spring 2021)

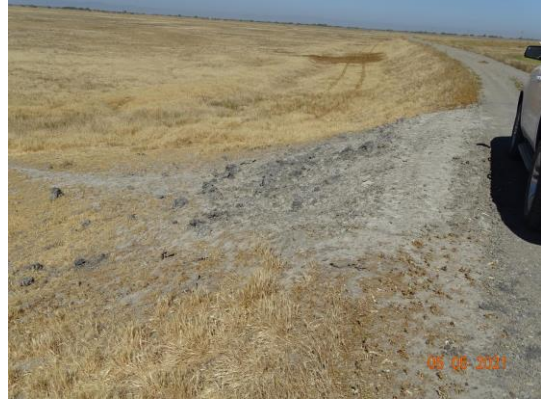
Photo 1 of 1 : SP_2022_NA0010_126_20_20220308_00004.jpg

LM Start	2.74	Rating **	A/W	Issue No.	20
LM End	2.74	Issue Type +	Ma	Location *	LS
Category	Earthen Levee			GPS Latitude/Longitude	
				Start	End
Item	Erosion / Livestock			37.252503 °	37.252503 °
				-120.733282 °	-120.733282 °
DWR ID	DWR_NA0010_08_f_2018_20				
Comment Code					
E4 : Repair the levee slope damaged by livestock and prevent large animal access.					
Inspector Comment					
Erosion from livestock has been repaired. Monitor for settlement.

View of repaired slope damage. (Spring 2021)

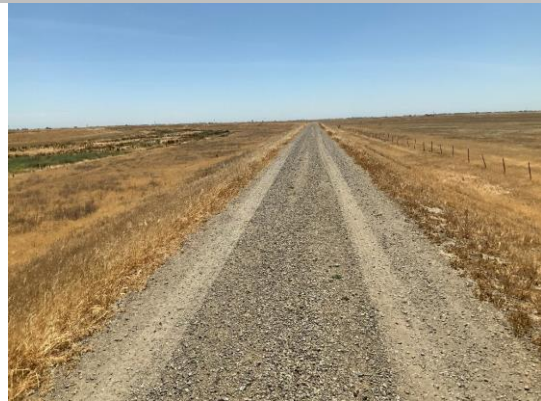
Photo 1 of 3 : UCIP_SP_2022_71185_99604.jpg

Comment Code						
Inspector Comment						
FS_ID:71185 DS_ID:19837 EP_NO: N/A Repair Type: Non-Urgent Crossing Status: Found UCIP Comments: 06/2/2021 The record has been upgraded from No Action Needed to Non-Urgent. DWR DMP internal inspection has not found pipe integrity issues. LOF of crossing is less or equal to 4.0. Recommend next video inspection in 5 years. No permit was found authorizing this encroachment. CVFPB will need to review crossing to determine owner. The UCIP inspection was completed with GEI staff, P. Espinoza. (H. Dunn ? GEI) FIELD_STRUCT_DESC: 24-inch corrugated metal gravity drainage pipe (CMP) through the levee, 10.5 feet below the crown. Flap gate on the waterside (WS) end. Concrete headwall on each end. [Additional Reference(s): DWR Levee Log, 2002, (HLM 2.77). USACE San Joaquin O&M Manual, Unit No. 601, Part No. 1, 1967, Amended in 1978, Revised 20 June 1985, (HLM 2.77). DWR As-Built Specification No. 63-25, Sheet No. 13, 9 May 1963, (HLM 2.77)]. FS Date: 6/2/2021

Levee crown looking downstream.

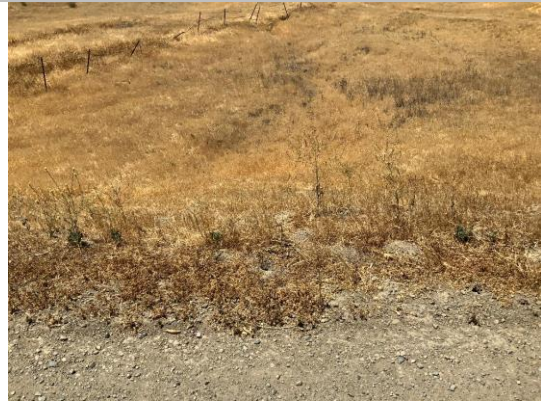
Photo 2 of 3 : UCIP_SP_2022_71185_99605.jpg

LS view: Toe from crown.

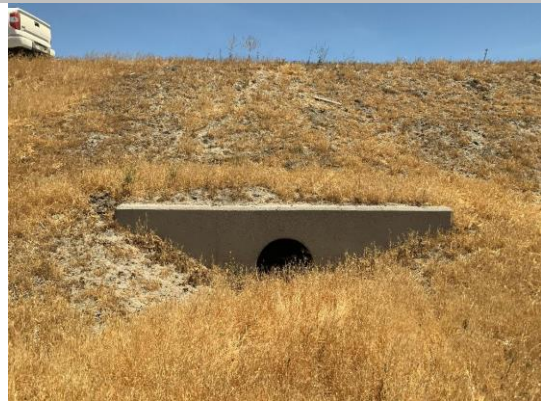
Photo 3 of 3 : UCIP_SP_2022_71185_99606.jpg

LS view: Slope and headwall at toe.

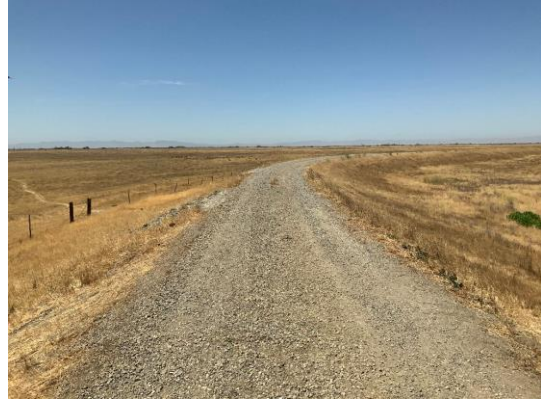
Photo 1 of 3 : UCIP_SP_2022_71186_99614.jpg

Comment Code						
Inspector Comment						
FS_ID:71186 DS_ID:19838 EP_NO: N/A Repair Type: Non-Urgent Crossing Status: Found UCIP Comments: 06/2/2021 Record remains Non-Urgent. LS pipe inlet has some sediment buildup, recommend cleaning out. No permit was found authorizing this encroachment. CVFPB will need to review crossing to determine owner. The UCIP inspection was completed with GEI staff, P. Espinoza. (H. Dunn ? GEI) 7/20/2016 LS inlet buried under dense vegetation. Dense vegetation limits the inspector's visibility to identify signs of pipe failure (leaks) along the WS and LS slope. Recommend removing vegetation along pipe alignment to conduct proper inspection of structure and appurtenances. (O. Magana - DWR UCIP)4/16/2014 Pipe blocked by silt on LS toe. Flapgate rusty and does not operate correctly. (W. Wylie - DWR UCIP) FIELD_STRUCT_DESC: 36-inch corrugated metal gravity drainage pipe (CMP) through the levee, 13.4 feet below the crown. Flap gate on the waterside (WS) end. Concrete headwall on each end. [Additional Reference(s): DWR Levee Log, 2002, (HLM 3.06). USACE San Joaquin O&M Manual, Unit No. 601, Part No. 1, 1967, Amended in 1978, Revised 20 June 1985, (HLM 3.06). DWR As-Built Specification No. 63-25, Sheet No. 13, 9 May 1963, (HLM 3.06)]. FS Date: 6/2/2021

Levee crown looking downstream.

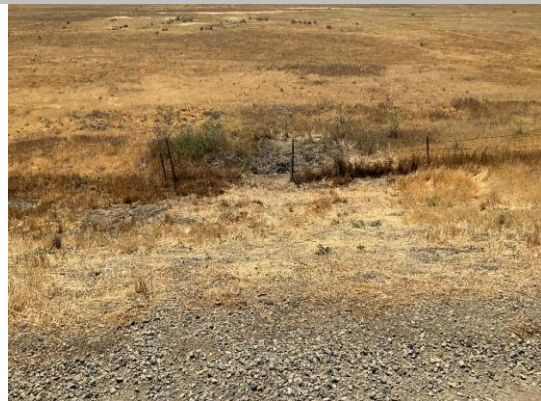
Photo 2 of 3 : UCIP_SP_2022_71186_99615.jpg

LS view: Toe from crown.

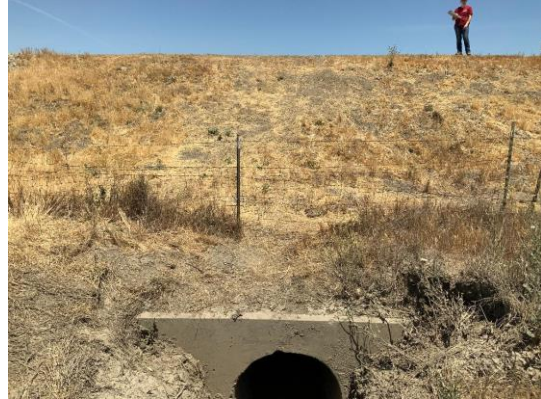
Photo 3 of 3 : UCIP_SP_2022_71186_99609.jpg

LS view: Slope and headwall at toe.

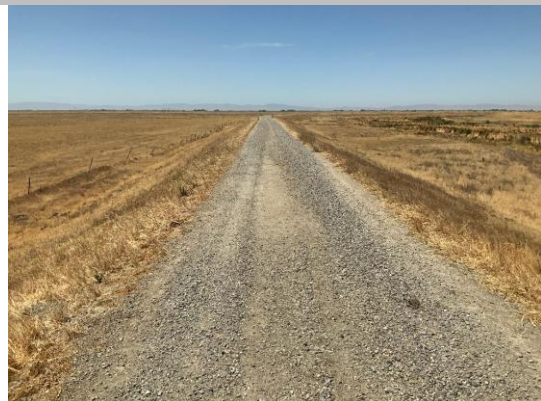
Photo 1 of 3 : UCIP_SP_2022_71187_99618.jpg

FS_ID:71187
DS_ID:19839
EP_NO: N/A
Repair Type: Non-Urgent
Crossing Status: Found
UCIP Comments: 06/2/2021 The record has been upgraded from No Action Needed to Non-Urgent. DWR DMP internal inspection has not found pipe integrity issues. LOF of crossing is less or equal to 4.0. Recommend next video inspection in 5 years. No permit was found authorizing this encroachment. CVFPB will need to review crossing to determine owner. The UCIP inspection was completed with GEI staff, P. Espinoza. (H. Dunn ? GEI)
FIELD_STRUCT_DESC: 24-inch corrugated metal gravity drainage pipe (CMP) through the levee, 10.0 feet below the crown. Flap gate on the waterside (WS) end. Concrete headwall on each end. [Additional Reference(s): DWR Levee Log, 2002, (HLM 3.23). USACE San Joaquin O&M Manual, Unit No. 601, Part No. 1, 1967, Amended in 1978, Revised 20 June 1985, (HLM 3.24). DWR As-Built Specification No. 63-25, Sheet No. 13, 9 May 1963, (HLM 3.24)].

Levee crown looking downstream

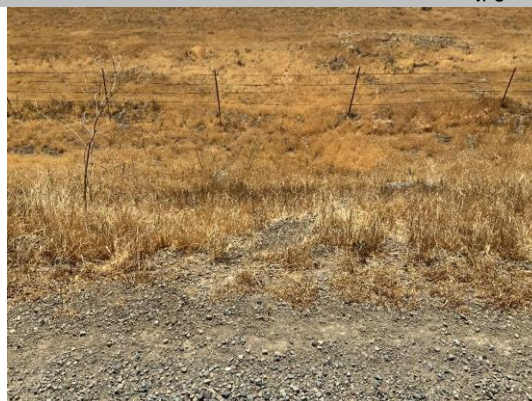
Photo 2 of 3 : UCIP_SP_2022_71187_99619.jpg

LS view: Toe from crown.

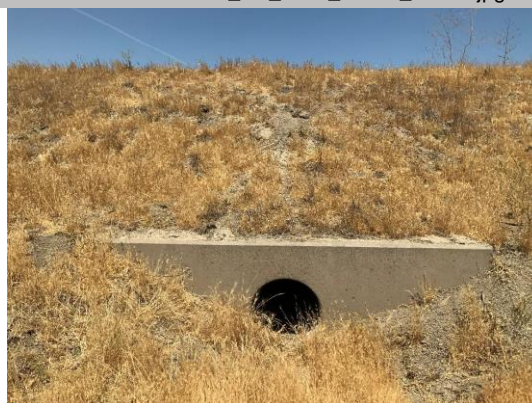
Photo 3 of 3 : UCIP_SP_2022_71187_99620.jpg

LS view: Slope and headwall at toe.

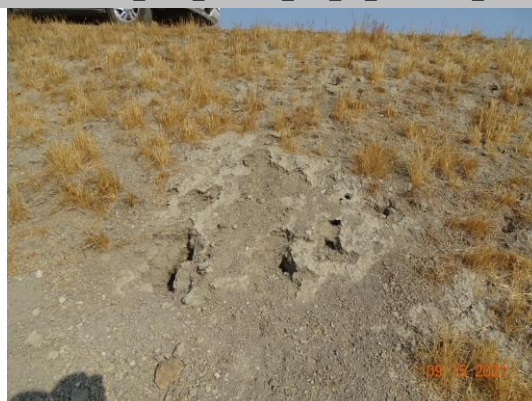
Photo 1 of 1 : SP_2022_NA0010_126_17_20220308_00002.jpg

LM Start	3.28	Rating **	M	Issue No.	17
LM End	3.28	Issue Type +	Ma	Location *	LS
Category	Earthen Levee			GPS Latitude/Longitude	
				Start	End
Item	Animal Control			37.252537 °	37.252537 °
				-120.724795 °	-120.724795 °
DWR ID	DWR_NA0010_08_f_2021_17				
Comment Code					
A3 : No rodents visible, but rodent burrows visible; need to backfill and compact or grout burrows.					
Inspector Comment

View of animal burrows in the landside slope. (Fall 2021)

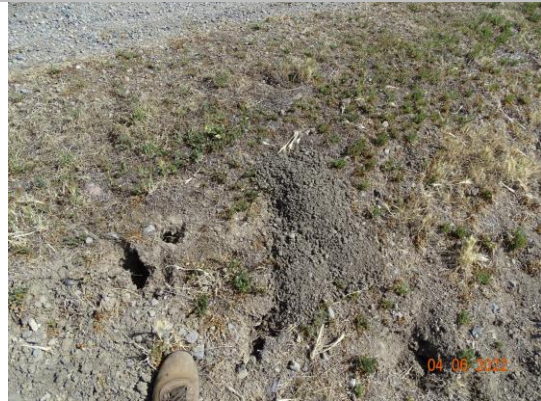
Photo 1 of 1 : SP_2022_NA0010_126_3_20220414_00046.jpg

LM Start	3.40	Rating **	A/W	Issue No.	3
LM End	3.54	Issue Type +	Ma	Location *	LS
Category	Earthen Levee			GPS Latitude/Longitude	
				Start	End
Item	Animal Control			37.253052 °	37.253600 °
				-120.722647 °	-120.720198 °
DWR ID	DWR_NA0010_08_s_2012_3				
Comment Code					
A3 : No rodents visible, but rodent burrows visible; need to backfill and compact or grout burrows.					
Inspector Comment					
Several rodent holes were noted on landside slope within this reach.

Looking at typical view of rodent holes on landward slope. (Spring 2022)

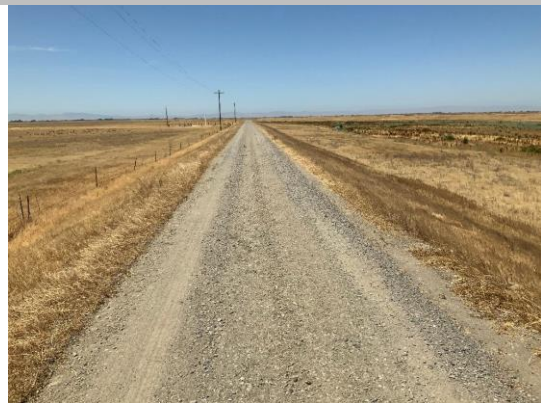
Photo 1 of 3 : UCIP_SP_2022_71188_99624.jpg

Comment Code						
Inspector Comment						
FS_ID:71188						
DS_ID:19840						
EP_NO: N/A						
Repair Type: Non-Urgent						
Crossing Status: Found						
UCIP Comments: 06/2/2021 Record remains Non-Urgent. LS pipe inlet blocked by barbed wire and both ends blocked by water, so limited inspection was done. No permit was found authorizing this encroachment. CVFPB will need to review crossing to determine owner. The UCIP inspection was completed with GEI staff, P. Espinoza. (H. Dunn ? GEI) 04/16/2014 No access available on landward side. Need to confirm status of crossing. (W. Wylie - DWR UCIP)						
FIELD_STRUCT_DESC: 24-inch corrugated metal gravity drainage pipe (CMP) through the levee, 13.0 feet below the crown. Flap gate on the waterside (WS) end. Concrete headwall on each end. [Additional Reference(s): DWR Levee Log, 2002, (HLM 3.43). USACE San Joaquin O&M Manual, Unit No. 601, Part No. 1, 1967, Amended in 1978, Revised 20 June 1985, (HLM 3.43). DWR As-Built Specification No. 63-25, Sheet No. 13, 9 May 1963, (HLM 3.43)].

Levee crown looking downstream.

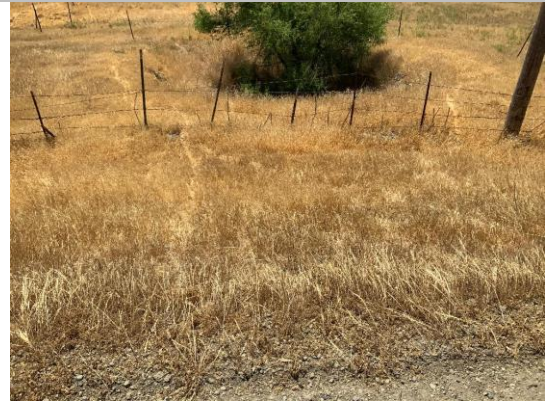
Photo 2 of 3 : UCIP_SP_2022_71188_99625.jpg

LS view: Toe from crown.

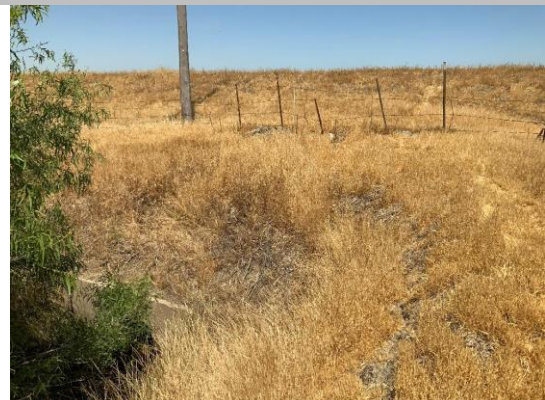
Photo 3 of 3 : UCIP_SP_2022_71188_99626.jpg

LS view: Slope from toe.

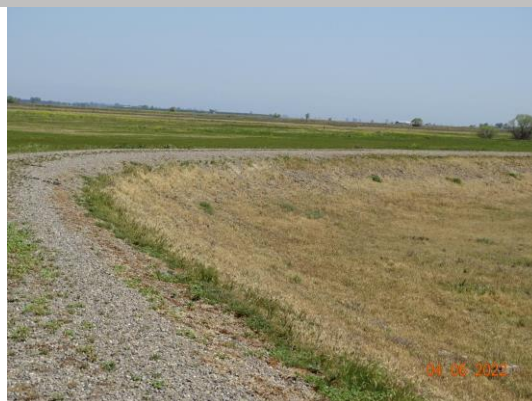
Photo 1 of 1 : SP_2022_NA0010_127_7_20220414_00013.jpg

LM Start	0.20	Rating **	A	Issue No.	7
LM End	0.20	Issue Type +	Ma	Location *	WS
Category	Earthen Levee			GPS Latitude/Longitude	
				Start	End
Item	Vegetation			37.219812 °	37.219812 °
				-120.709904 °	-120.709904 °
DWR ID	DWR_NA0010_09_s_2022_7				
Comment Code					
V1 : Control annual grass and weeds on the levee slopes and easements.					
Inspector Comment

View of vegetation management on the waterside slope. (Spring 2022)
